**Flood Control Project Maintenance  
Levee Inspections**  
**LMA District Cover Sheet**  
**Spring 2017 Levee Inspection Results**

**Lower San Joaquin Levee District**

Waterway			Bank	Unit Miles
Unit No. 01 San Joaquin River			Right	22.52
	Spring (March - May)	Summer (June - August)	(September - November) Fall	Winter (December - February)
Unit Maintenance Rating (Fall Only)				
Date of Inspection	4/17/2017 - 4/20/2017			
DWR Inspector	Richard Willoughby			
Accompanied By

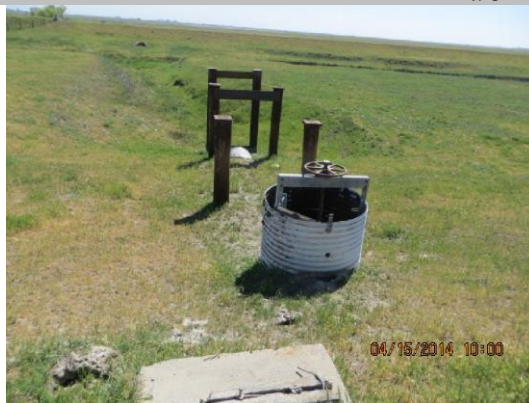
Photo 1 of 3 : UCIP\_SP\_2017\_33713\_60963.jpg

Comment Code					
Inspector Comment					
FS_ID:33713					
DS_ID:19894					
EP_NO: N/A					
Repair Type: Non-Urgent					
Crossing Status: Found					
UCIP Comments: Slide gate not operable, but left in closed position.					
Need to reinstall covers over slide gate standpipe.					
FIELD_STRUCT_DESC: 36-inch C.M stormdrain pipe through the					
levee, 9.7 feet below the crown. Slide gate in 48-inch C.M. pipe riser in					
the landward slope. Concrete "U" headwall on the landward end, inlet					
channel cobble revetted. Dilapidated wooden pier on WS. Waterward					
slope and outlet ditch cobble revetted. (USACE-1967). This entry					
matches the Drainage or Irrigation Structure referenced in O&M manual					
(HLM 0.49).					
FS Date: 4/15/2014

Slide gate in CMP riser on WS slope.

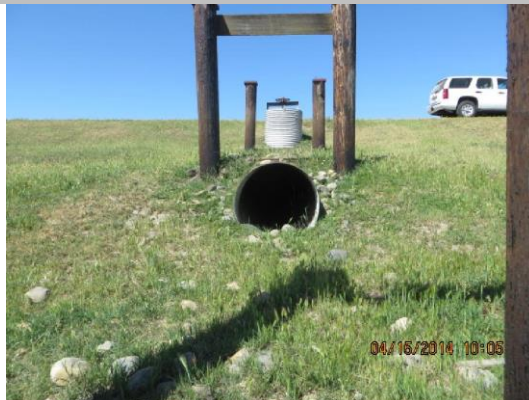
Photo 2 of 3 : UCIP\_SP\_2017\_33713\_60965.jpg

Outlet on WS slope.

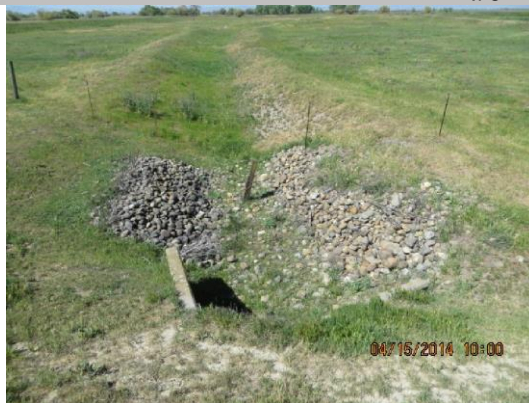
Photo 3 of 3 : UCIP\_SP\_2017\_33713\_60964.jpg

Comment Code						
Inspector Comment						
FS_ID:33713						
DS_ID:19894						
EP_NO: N/A						
Repair Type: Non-Urgent						
Crossing Status: Found						
UCIP Comments: Slide gate not operable, but left in closed position.						
Need to reinstall covers over slide gate standpipe.						
FIELD_STRUCT_DESC: 36-inch C.M stormdrain pipe through the						
levee, 9.7 feet below the crown. Slide gate in 48-inch C.M. pipe riser in						
the landward slope. Concrete "U" headwall on the landward end, inlet						
channel cobble revetted. Dilapidated wooden pier on WS. Waterward						
slope and outlet ditch cobble revetted. (USACE-1967). This entry						
matches the Drainage or Irrigation Structure referenced in O&M manual						
(HLM 0.49).						
FS Date: 4/15/2014

Pipe and headwall on LS toe.

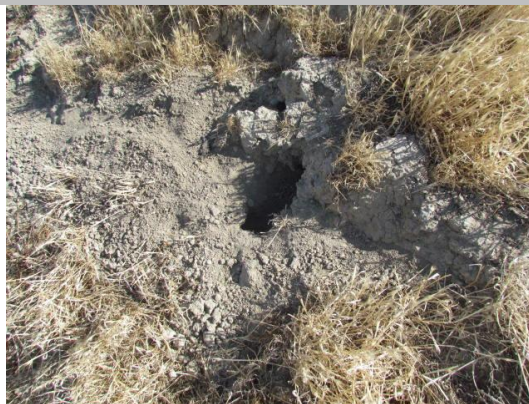
Photo 1 of 1 : SP\_2017\_NA0010\_125\_29\_20170417\_00005.jpg

LM Start	0.50	Rating **	M	Issue No.	29
LM End	0.50	Issue Type +	Ma	Location *	LS
Category	Earthen Levee			GPS Latitude/Longitude	
				Start	End
Item	Animal Control			37.258722 °	37.258722 °
				-120.764867 °	-120.764867 °
DWR ID	DWR_NA0010_07_s_2012_29				
Comment Code					
A3 : No rodents visible, but rodent burrows visible; need to backfill and compact or grout burrows.					
Inspector Comment					
Several rodent holes noted on landward and waterward slope and shoulder.

Looking at typical view of rodent holes on landward slope.

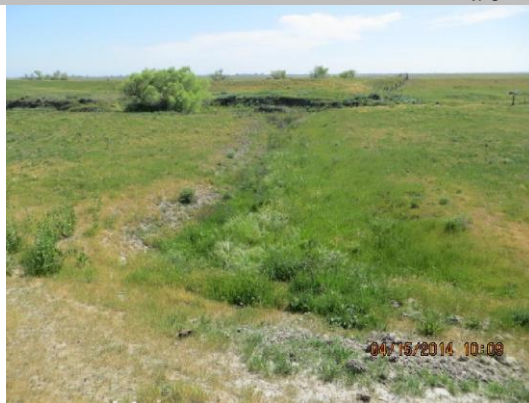
Photo 1 of 3 : UCIP\_SP\_2017\_33723\_60981.jpg

LM Start	0.53	Rating **	A/W	Issue No.	33
LM End	0.53	Issue Type +	Ma	Location *	LS
Category	Supplemental			GPS Latitude/Longitude	
				Start	End
Item	DWR UCIP LMA Responsibility			37.259163 °	37.259163 °
				-120.764860 °	-120.764860 °
DWR ID					
Comment Code					
Inspector Comment					
FS_ID:33723					
DS_ID:19895					
EP_NO: N/A					
Repair Type: No Action Needed					
Crossing Status: Found					
UCIP Comments:					
FIELD_STRUCT_DESC: 24-inch C.M. stormdrain pipe through the					
levee, 9-feet below the crown. Flap gate on the waterward end.					
Concrete headwall with a wooden wier at inlet on LS toe. Concrete "U"-					
shaped headwall on the WS toe (USACE-1967). This entry matches the					
Drainage or Irrigation Structure referenced in O&M manual (HLM 0.53).					
FS Date: 4/15/2014

Headwall and flapgate on WS toe.

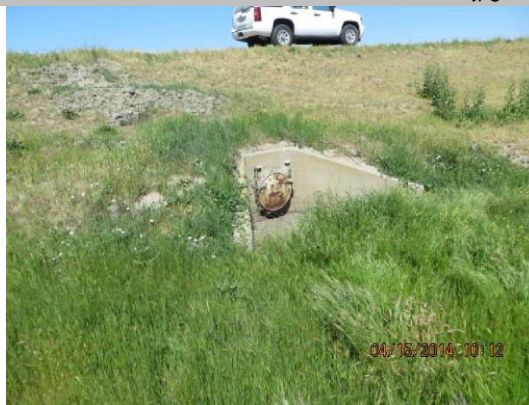
Photo 2 of 3 : UCIP\_SP\_2017\_33723\_60983.jpg

Flapgate on concrete headwall at WS toe.

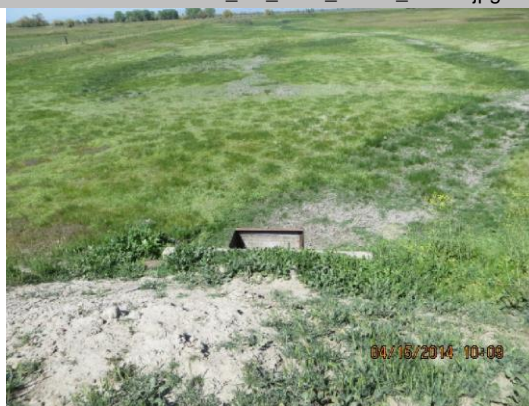
Photo 3 of 3 : UCIP\_SP\_2017\_33723\_60982.jpg

LM Start	0.53	Rating **	A/W	Issue No.	33 (cont)	
LM End	0.53	Issue Type +	Ma	Location *	LS	
Category	Supplemental			GPS Latitude/Longitude		
				Start		End
Item	DWR UCIP LMA Responsibility			37.259163 °		37.259163 °
				-120.764860 °		-120.764860 °
DWR ID						
Comment Code						
Inspector Comment						
FS_ID:33723						
DS_ID:19895						
EP_NO: N/A						
Repair Type: No Action Needed						
Crossing Status: Found						
UCIP Comments:						
FIELD_STRUCT_DESC: 24-inch C.M. stormdrain pipe through the						
levee, 9-feet below the crown. Flap gate on the waterward end.						
Concrete headwall with a wooden wier at inlet on LS toe. Concrete "U"-						
shaped headwall on the WS toe (USACE-1967). This entry matches the						
Drainage or Irrigation Structure referenced in O&M manual (HLM 0.53).						
FS Date: 4/15/2014

Headwall, pipe, and wier on LS toe.

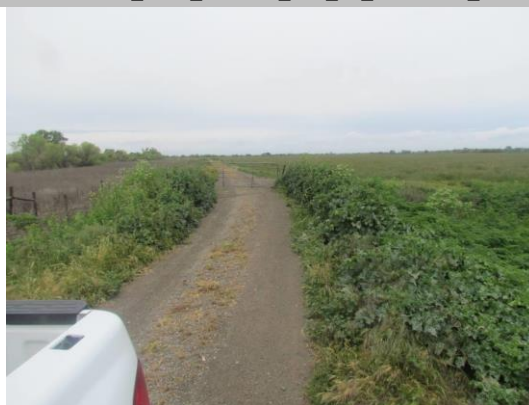
Photo 1 of 1 : SP\_2017\_NA0010\_125\_16\_20170425\_00039.jpg

LM Start	0.55	Rating **	U	Issue No.	16
LM End	1.16	Issue Type +	Ma	Location *	LS
Category	Earthen Levee			GPS Latitude/Longitude	
				Start	End
Item	Vegetation			37.259460 °	37.264452 °
				-120.764748 °	-120.756797 °
DWR ID	DWR_NA0010_07_s_2017_16				
Comment Code					
V1 : Control annual grass and weeds on the levee slopes and easements.					
Inspector Comment

Looking upstream at dense veg. on landward slope.

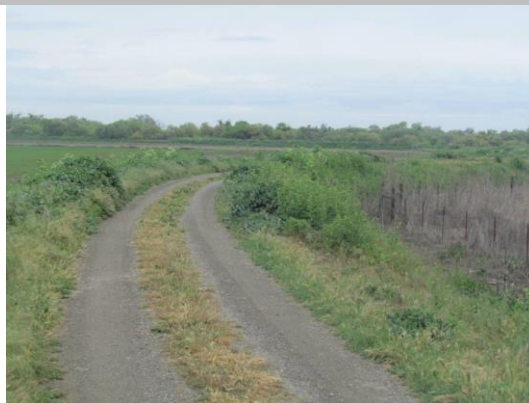
Photo 1 of 1 : SP\_2017\_NA0010\_125\_17\_20170425\_00040.jpg

LM Start	0.55	Rating **	U	Issue No.	17
LM End	1.16	Issue Type +	Ma	Location *	WS
Category	Earthen Levee			GPS Latitude/Longitude	
				Start	End
Item	Vegetation			37.259460 °	37.264452 °
				-120.764748 °	-120.756793 °
DWR ID	DWR_NA0010_07_s_2017_17				
Comment Code					
V1 : Control annual grass and weeds on the levee slopes and easements.					
Inspector Comment

Looking downstream at dense veg on waterward slope.

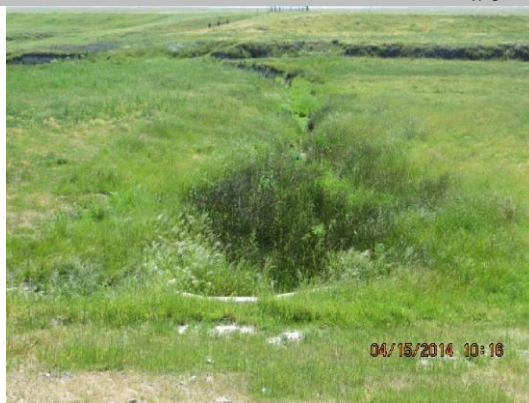
Photo 1 of 3 : UCIP\_SP\_2017\_39507\_60986.jpg

LM Start	0.85	Rating **	M	Issue No.	34
LM End	0.85	Issue Type +	Ma	Location *	WS
Category	Supplemental			GPS Latitude/Longitude	
				Start	End
Item	DWR UCIP LMA Responsibility			37.262981 °	37.262981 °
				-120.761703 °	-120.761703 °
DWR ID					
Comment Code					
Inspector Comment					
FS_ID:39507 DS_ID:19896 EP_NO: N/A Repair Type: Non-Urgent Crossing Status: Found UCIP Comments: Need to contact owner. Heavy sediment buildup at inlet due to animal activity should be cleared. FIELD_STRUCT_DESC: 24-inch C.M. stormdrain pipe through the levee, 9.8-feet below the crown. Flap gate on the waterward end. Wooden weir on concrete headwall at the LS toe. 36-inch concrete riser at LS toe. Concrete "U" headwall on the waterward end. Concrete standpipe on landward side. (USACE-1967). This entry matches the Drainage or Irrigation Structure referenced in O&M manual (HLM 0.85). FS Date: 4/15/2014

Headwall and flapgate on WS toe.

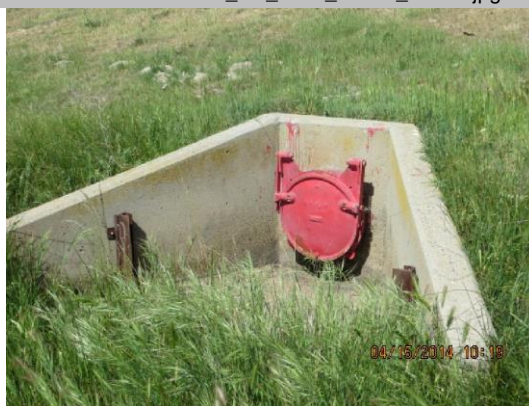
Photo 2 of 3 : UCIP\_SP\_2017\_39507\_60988.jpg

Comment Code					
Inspector Comment					
FS_ID:39507 DS_ID:19896 EP_NO: N/A Repair Type: Non-Urgent Crossing Status: Found UCIP Comments: Need to contact owner. Heavy sediment buildup at inlet due to animal activity should be cleared. FIELD_STRUCT_DESC: 24-inch C.M. stormdrain pipe through the levee, 9.8-feet below the crown. Flap gate on the waterward end. Wooden weir on concrete headwall at the LS toe. 36-inch concrete riser at LS toe. Concrete "U" headwall on the waterward end. Concrete standpipe on landward side. (USACE-1967). This entry matches the Drainage or Irrigation Structure referenced in O&M manual (HLM 0.85). FS Date: 4/15/2014

Headwall and flapgate on WS toe.

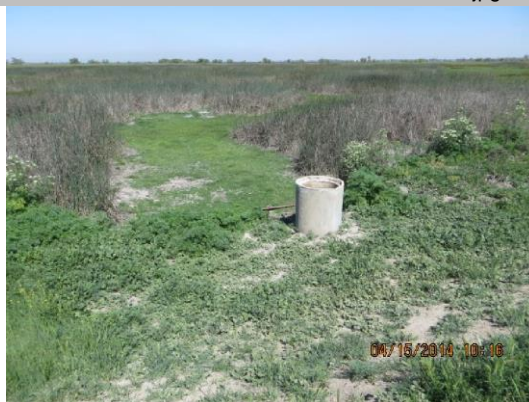
Photo 3 of 3 : UCIP\_SP\_2017\_39507\_60987.jpg

Concrete riser, concrete headwall, weir, and pipe at LS toe.

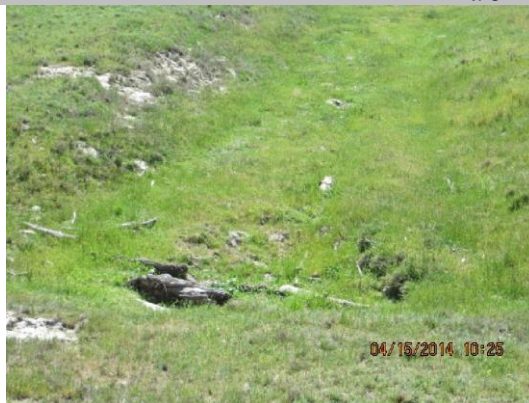
Photo 1 of 3 : UCIP\_SP\_2017\_33725\_60991.jpg

LM Start	0.94	Rating **	A/W	Issue No.	35
LM End	0.94	Issue Type +	Ma	Location *	WS
Category	Supplemental			GPS Latitude/Longitude	
				Start	End
Item	DWR UCIP LMA Responsibility			37.263950 °	37.263950 °
				-120.760572 °	-120.760572 °
DWR ID					
Comment Code					
Inspector Comment					
FS_ID:33725					
DS_ID:19897					
EP_NO: N/A					
Repair Type: No Action Needed					
Crossing Status: Found					
UCIP Comments:					
FIELD_STRUCT_DESC: 24-inch C.M. stormdrain pipe through the					
levee, 11.5-feet below the crown. Flap gate on the waterward end.					
Concrete headwall on the landward end. Concrete "U" headwall on the					
waterward end. (USACE-1967). This entry matches the Drainage or					
Irrigation Structure referenced in O&M manual (HLM 0.94).					
FS Date: 4/15/2014

Concrete headwall and flapgate at WS toe.

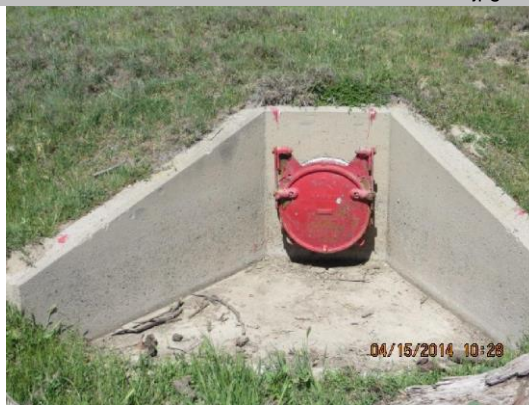
Photo 2 of 3 : UCIP\_SP\_2017\_33725\_60993.jpg

Concrete headwall and flapgate at WS toe.

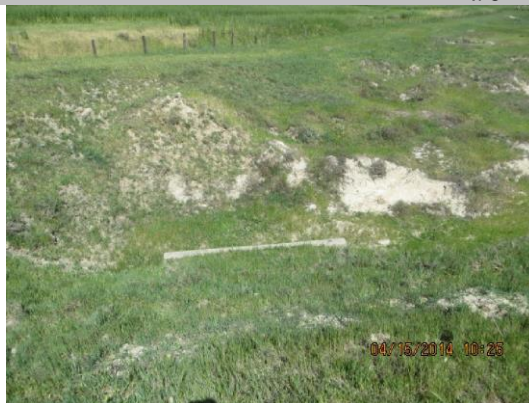
Photo 3 of 3 : UCIP\_SP\_2017\_33725\_60992.jpg

LM Start	0.94	Rating **	A/W	Issue No.	35 (cont)	
LM End	0.94	Issue Type +	Ma	Location *	WS	
Category	Supplemental			GPS Latitude/Longitude		
				Start		End
Item	DWR UCIP LMA Responsibility			37.263950 °		37.263950 °
				-120.760572 °		-120.760572 °
DWR ID						
Comment Code						
Inspector Comment						
FS_ID:33725						
DS_ID:19897						
EP_NO: N/A						
Repair Type: No Action Needed						
Crossing Status: Found						
UCIP Comments:						
FIELD_STRUCT_DESC: 24-inch C.M. stormdrain pipe through the levee, 11.5-feet below the crown. Flap gate on the waterward end. Concrete headwall on the landward end. Concrete "U" headwall on the waterward end. (USACE-1967). This entry matches the Drainage or Irrigation Structure referenced in O&M manual (HLM 0.94).						
FS Date: 4/15/2014

Concrete headwall and pipe on LS toe.

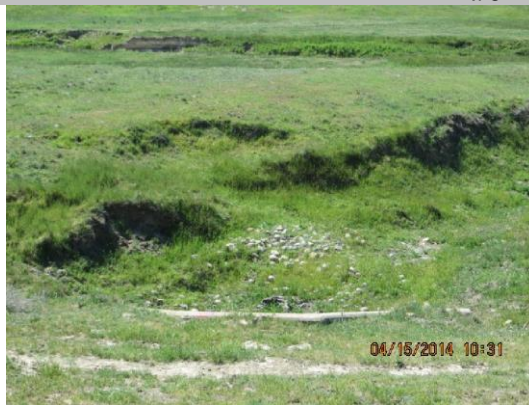
Photo 1 of 3 : UCIP\_SP\_2017\_33726\_60996.jpg

LM Start	1.17	Rating **	A/W	Issue No.	36
LM End	1.17	Issue Type +	Ma	Location *	WS
Category	Supplemental			GPS Latitude/Longitude	
				Start	End
Item	DWR UCIP LMA Responsibility			37.264421 °	37.264421 °
				-120.756683 °	-120.756683 °
DWR ID					
Comment Code					
Inspector Comment					
FS_ID:33726					
DS_ID:19898					
EP_NO: N/A					
Repair Type: No Action Needed					
Crossing Status: Found					
UCIP Comments:					
FIELD_STRUCT_DESC: 48-inch C.M stormdrain pipe through the					
levee, 14.6-feet below the crown. Flap gate on the waterward end.					
Concrete "U" headwalls on both ends. (USACE-1967). This entry					
matches the Drainage or Irrigation Structure referenced in O&M manual					
(HLM 1.17).					
FS Date: 4/15/2014

Pipe, flapgate, and headwall on WS toe.

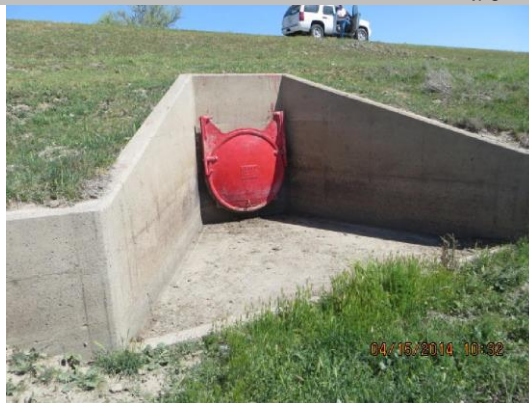
Photo 2 of 3 : UCIP\_SP\_2017\_33726\_60995.jpg

LM Start	1.17	Rating **	A/W	Issue No.	36 (cont)	
LM End	1.17	Issue Type +	Ma	Location *	WS	
Category	Supplemental			GPS Latitude/Longitude		
				Start		End
Item	DWR UCIP LMA Responsibility			37.264421 °	37.264421 °	
				-120.756683 °	-120.756683 °	
DWR ID						
Comment Code						
Inspector Comment						
FS_ID:33726						
DS_ID:19898						
EP_NO: N/A						
Repair Type: No Action Needed						
Crossing Status: Found						
UCIP Comments:						
FIELD_STRUCT_DESC: 48-inch C.M stormdrain pipe through the						
levee, 14.6-feet below the crown. Flap gate on the waterward end.						
Concrete "U" headwalls on both ends. (USACE-1967). This entry						
matches the Drainage or Irrigation Structure referenced in O&M manual						
(HLM 1.17).						
FS Date: 4/15/2014

Flapgate at headwall on WS toe.

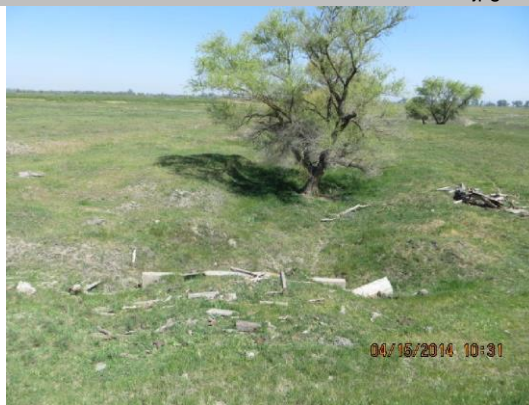
Photo 3 of 3 : UCIP\_SP\_2017\_33726\_60997.jpg

Pipe and headwall on LS toe.

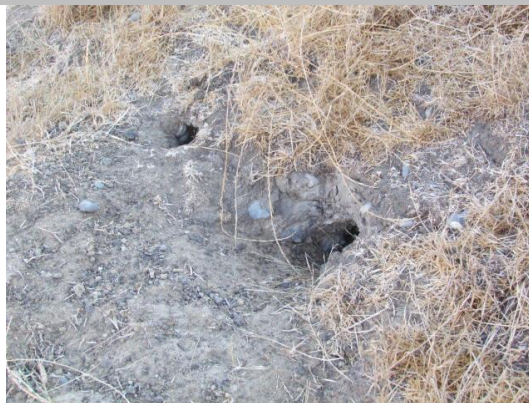
Photo 1 of 2 : SP\_2017\_NA0010\_125\_1\_20170417\_00001.jpg

LM Start	<b>1.22</b>	Rating **	M	Issue No.	<b>1 (cont)</b>
LM End	<b>1.22</b>	Issue Type +	Ma	Location *	LS

Looking north at several rodent holes on landward slope.

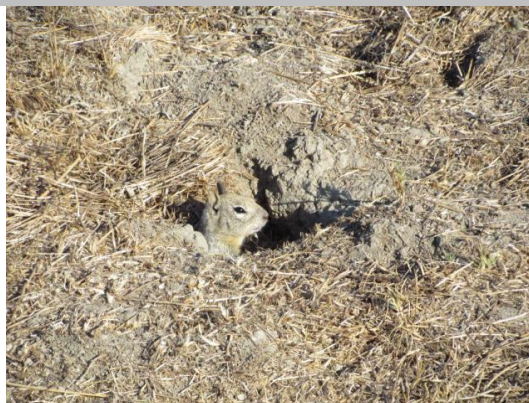
Photo 2 of 2 : SP\_2017\_NA0010\_125\_1\_20170417\_00002.jpg

Looking at east at active rodent holes on landside berm.

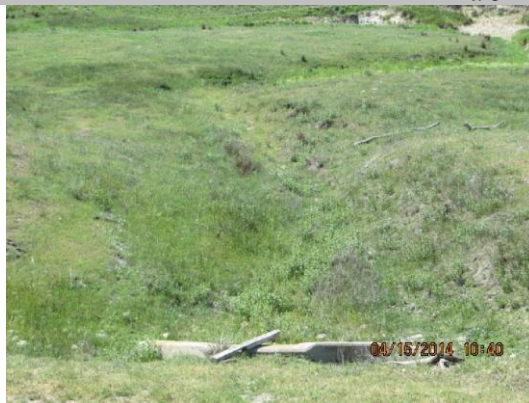
Photo 1 of 3 : UCIP\_SP\_2017\_33727\_61001.jpg

LM Start	1.50	Rating **	A/W	Issue No.	37
LM End	1.50	Issue Type +	Ma	Location *	LS
Category	Supplemental			GPS Latitude/Longitude	
				Start	End
Item	DWR UCIP LMA Responsibility			37.263917 °	37.263917 °
				-120.750694 °	-120.750694 °
DWR ID					
Comment Code					
Inspector Comment					
FS_ID:33727					
DS_ID:19902					
EP_NO: N/A					
Repair Type: No Action Needed					
Crossing Status: Found					
UCIP Comments:					
FIELD_STRUCT_DESC: 24-inch C.M. stormdrain pipe through the					
levee, 14.0-feet below the crown. Flap gate on the waterward end.					
Concrete "U" headwalls on both ends. (USACE-1967). This entry					
matches the Drainage or Irrigation Structure referenced in O&M manual					
(HLM 1.51).					
FS Date: 4/15/2014

Pipe, headwall and flapgate on WS toe.

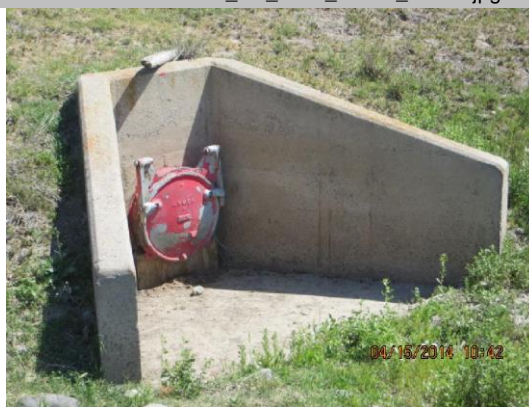
Photo 2 of 3 : UCIP\_SP\_2017\_33727\_61003.jpg

Pipe, headwall and flapgate on WS toe.

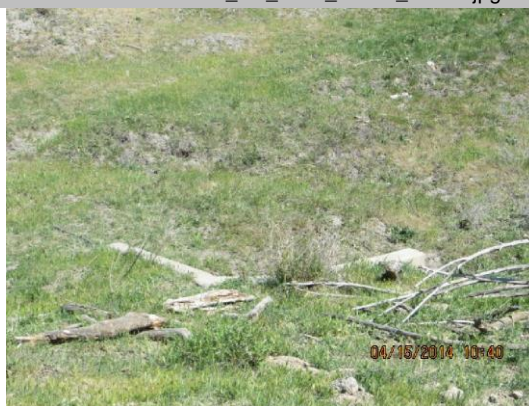
Photo 3 of 3 : UCIP\_SP\_2017\_33727\_61002.jpg

LM Start	1.50	Rating **	A/W	Issue No.	37 (cont)	
LM End	1.50	Issue Type +	Ma	Location *	LS	
Category	Supplemental			GPS Latitude/Longitude		
				Start		End
Item	DWR UCIP LMA Responsibility			37.263917 °		37.263917 °
				-120.750694 °		-120.750694 °
DWR ID						
Comment Code						
Inspector Comment						
FS_ID:33727						
DS_ID:19902						
EP_NO: N/A						
Repair Type: No Action Needed						
Crossing Status: Found						
UCIP Comments:						
FIELD_STRUCT_DESC: 24-inch C.M. stormdrain pipe through the						
levee, 14.0-feet below the crown. Flap gate on the waterward end.						
Concrete "U" headwalls on both ends. (USACE-1967). This entry						
matches the Drainage or Irrigation Structure referenced in O&M manual						
(HLM 1.51).						
FS Date: 4/15/2014

Headwall and pipe on LS toe.

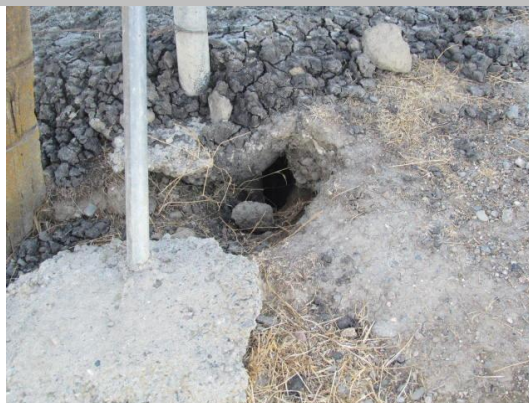
Photo 1 of 2 : SP\_2017\_NA0010\_125\_12\_20170417\_00003.jpg

LM Start	2.09	Rating **	M	Issue No.	12
LM End	2.09	Issue Type +	Ma	Location *	LS
Category	Earthen Levee			GPS Latitude/Longitude	
				Start	End
Item	Animal Control			37.259187 °	37.259187 °
				-120.742551 °	-120.742551 °
DWR ID	DWR_NA0010_07_f_2014_12				
Comment Code					
A3 : No rodents visible, but rodent burrows visible; need to backfill and compact or grout burrows.					
Inspector Comment					
Rodent activity noted next to fence post.

Looking east at rodent hole next to fence post on landward shoulder.

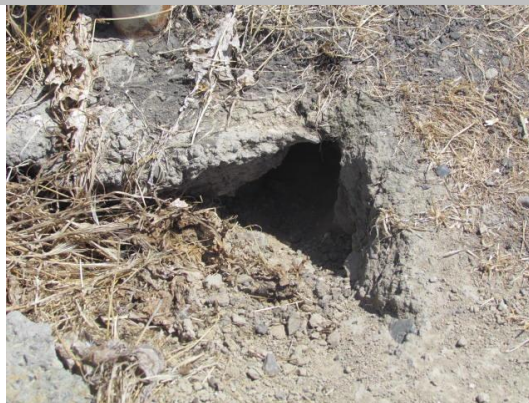
Photo 2 of 2 : SP\_2017\_NA0010\_125\_12\_20170417\_00004.jpg

Looking at rodent activity next to fence post

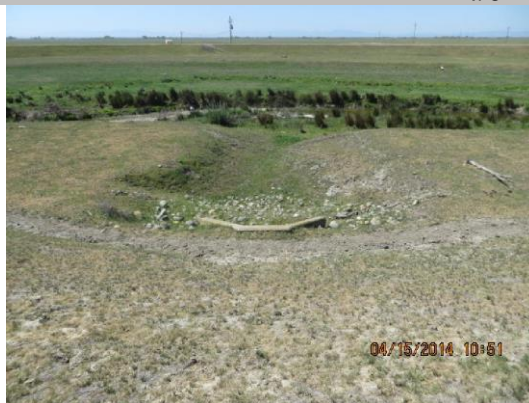
Photo 1 of 3 : UCIP\_SP\_2017\_33728\_61006.jpg

LM Start	2.48	Rating **	A/W	Issue No.	38
LM End	2.48	Issue Type +	Ma	Location *	LS
Category	Supplemental			GPS Latitude/Longitude	
				Start	End
Item	DWR UCIP LMA Responsibility			37.255803 °	37.255803 °
				-120.737246 °	-120.737246 °
DWR ID					
Comment Code					
Inspector Comment					
FS_ID:33728					
DS_ID:19899					
EP_NO: N/A					
Repair Type: No Action Needed					
Crossing Status: Found					
UCIP Comments:					
FIELD_STRUCT_DESC: 24-inch C.M. stormdrain pipe through the					
levee, 9.5-feet below the crown. Flap gate on the waterward end.					
Concrete headwall on the landward end. Concrete "U" headwall on the					
waterward end. (USACE-1967). This entry matches the Drainage or					
Irrigation Structure referenced in O&M manual (HLM 2.48).					
FS Date: 4/15/2014

Headwall and flapgate on WS toe.

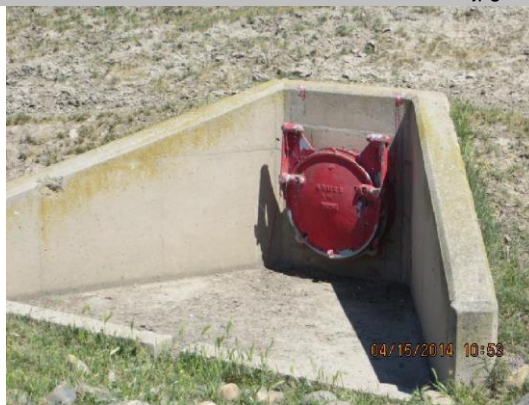
Photo 2 of 3 : UCIP\_SP\_2017\_33728\_61008.jpg

Concrete headwall and flapgate at WS toe.

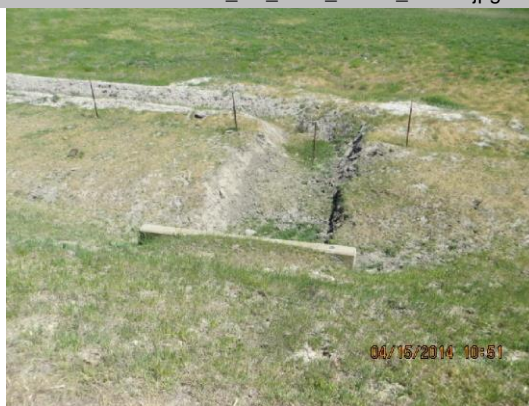
Photo 3 of 3 : UCIP\_SP\_2017\_33728\_61007.jpg

Concrete headwall and pipe on LS toe.

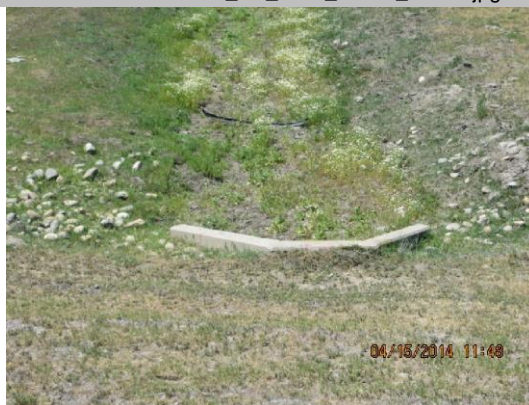
Photo 1 of 3 : UCIP\_SP\_2017\_33729\_61011.jpg

LM Start	2.63	Rating **	A/W	Issue No.	39
LM End	2.63	Issue Type +	Ma	Location *	LS
Category	Supplemental			GPS Latitude/Longitude	
				Start	End
Item	DWR UCIP LMA Responsibility			37.254832 °	37.254832 °
				-120.734918 °	-120.734918 °
DWR ID					
Comment Code					
Inspector Comment					
FS_ID:33729					
DS_ID:19900					
EP_NO: N/A					
Repair Type: No Action Needed					
Crossing Status: Found					
UCIP Comments:					
FIELD_STRUCT_DESC: 24-inch C.M stormdrain pipe through the					
levee, 11.5-feet below the crown. Flap gate on the waterward end.					
Concrete headwall on the landward end. Concrete "U" headwall on the					
waterward end. (USACE-1967). This entry matches the Drainage or					
Irrigation Structure referenced in O&M manual (HLM 2.64).					
FS Date: 4/15/2014

Concrete headwall and flapgate on WS toe.

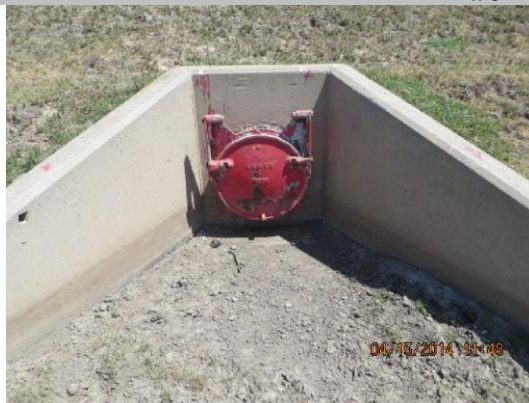
Photo 2 of 3 : UCIP\_SP\_2017\_33729\_61010.jpg

Concrete headwall and flapgate on WS toe.

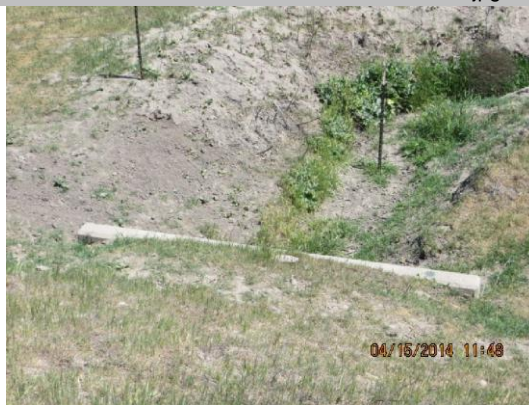
Photo 3 of 3 : UCIP\_SP\_2017\_33729\_61012.jpg

Concrete headwall and pipe at LS toe.

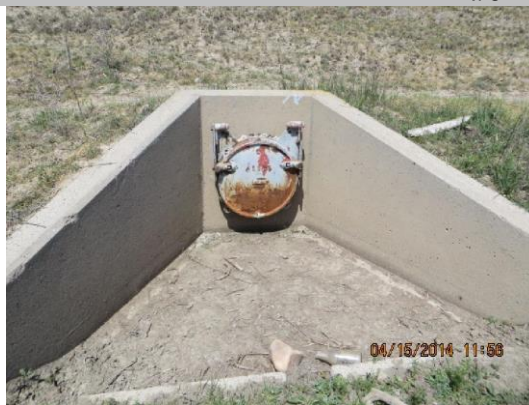
Photo 2 of 3 : UCIP\_SP\_2017\_39508\_61015.jpg

Headwall, pipe, and flapgate on WS toe.

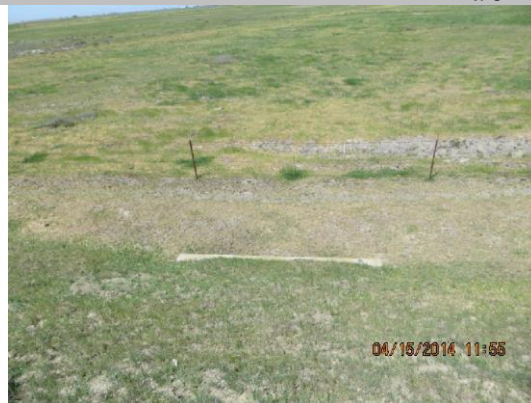
Photo 3 of 3 : UCIP\_SP\_2017\_39508\_61017.jpg

Headwall and pipe on LS toe.

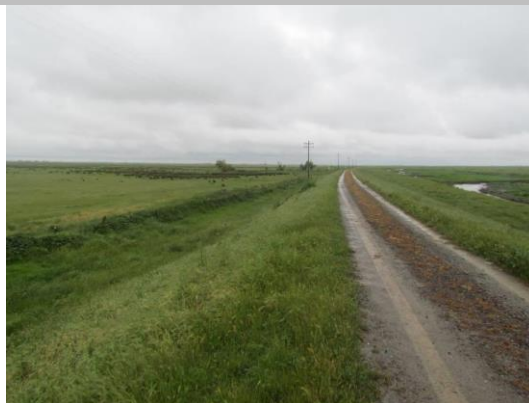
Photo 1 of 1 : SP\_2017\_NA0010\_126\_20\_20170425\_00041.jpg

LM Start	0.00	Rating **	M	Issue No.	20
LM End	3.63	Issue Type +	Ma	Location *	LS
Category	Earthen Levee			GPS Latitude/Longitude	
				Start	End
Item	Vegetation			37.253072 °	37.254037 °
				-120.768442 °	-120.718832 °
DWR ID	DWR_NA0010_08_s_2017_20				
Comment Code					
V1 : Control annual grass and weeds on the levee slopes and easements.					
Inspector Comment

Looking downstream at typical view of landward slope.

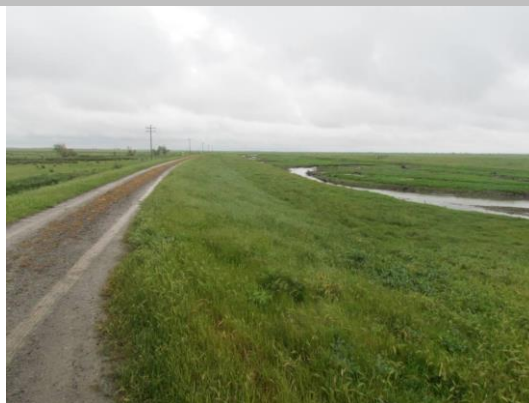
Photo 1 of 1 : SP\_2017\_NA0010\_126\_21\_20170425\_00042.jpg

LM Start	0.00	Rating **	M	Issue No.	21
LM End	3.63	Issue Type +	Ma	Location *	WS
Category	Earthen Levee			GPS Latitude/Longitude	
				Start	End
Item	Vegetation			37.253072 °	37.254037 °
				-120.768442 °	-120.718832 °
DWR ID	DWR_NA0010_08_s_2017_21				
Comment Code					
V1 : Control annual grass and weeds on the levee slopes and easements.					
Inspector Comment

Looking downstream at typical view of waterward slope.

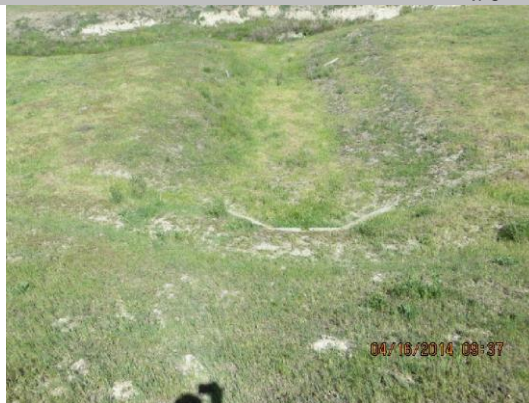
Photo 1 of 3 : UCIP\_SP\_2017\_33751\_61068.jpg

LM Start	0.23	Rating **	A/W	Issue No.	22
LM End	0.23	Issue Type +	Ma	Location *	WS
Category	Supplemental			GPS Latitude/Longitude	
				Start	End
Item	DWR UCIP LMA Responsibility			37.256092 °	37.256092 °
				-120.767873 °	-120.767873 °
DWR ID					
Comment Code					
Inspector Comment					
FS_ID:33751					
DS_ID:19903					
EP_NO: N/A					
Repair Type: No Action Needed					
Crossing Status: Found					
UCIP Comments:					
FIELD_STRUCT_DESC: 24-inch CM stormdrain pipe through levee, 9.6-					
feet below crown. Flap gate on the waterward end. Concrete headwall					
on the landward end. Concrete "U" headwall on the waterward end.					
(USACE-1967). This entry matches the Drainage or Irrigation Structure					
referenced in O&M manual (HLM 0.23).					
FS Date: 4/16/2014

Headwall and flapgate on WS toe.

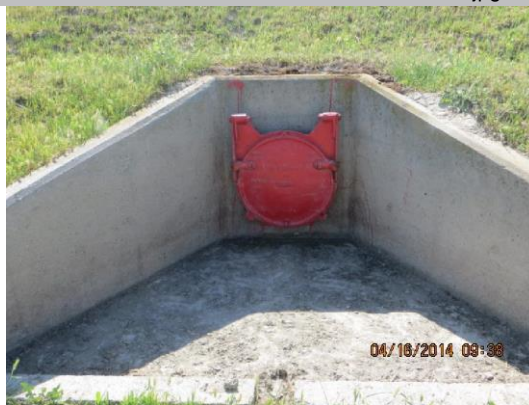
Photo 2 of 3 : UCIP\_SP\_2017\_33751\_61067.jpg

Headwall and flapgate on WS toe.

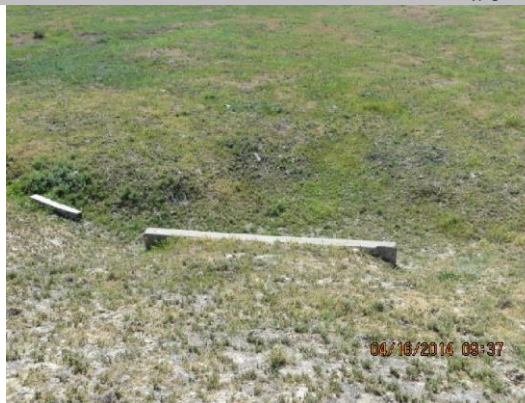
Photo 3 of 3 : UCIP\_SP\_2017\_33751\_61069.jpg

Concrete headwall on LS toe.

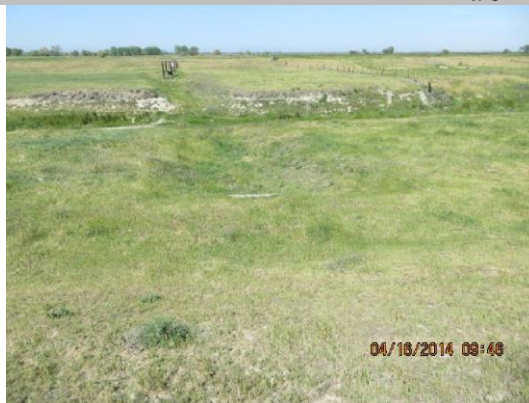
Photo 1 of 3 : UCIP\_SP\_2017\_33752\_61073.jpg

LM Start	0.57	Rating **	A/W	Issue No.	23
LM End	0.57	Issue Type +	Ma	Location *	WS
Category	Supplemental			GPS Latitude/Longitude	
				Start	End
Item	DWR UCIP LMA Responsibility			37.258604 °	37.258604 °
				-120.763588 °	-120.763588 °
DWR ID					
Comment Code					
Inspector Comment					
FS_ID:33752					
DS_ID:19904					
EP_NO: N/A					
Repair Type: No Action Needed					
Crossing Status: Found					
UCIP Comments:					
FIELD_STRUCT_DESC: 24-inch CM stormdrain pipe through levee, 12.4-feet below crown. Flap gate on the waterward end. Concrete headwall on both ends. (USACE-1967). This entry matches the Drainage or Irrigation Structure referenced in O&M manual (HLM 0.57). FS Date: 4/16/2014

Pipe, flapgate and headwall on WS toe.

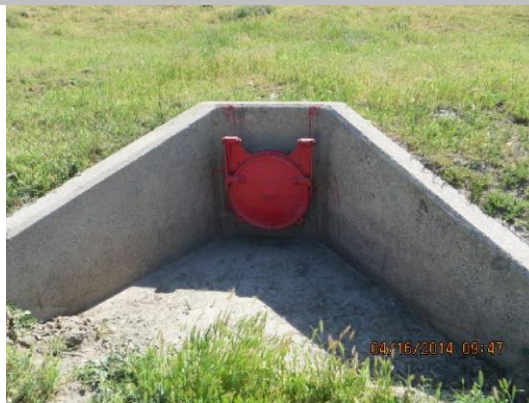
Photo 2 of 3 : UCIP\_SP\_2017\_33752\_61072.jpg

Pipe, flapgate and headwall on WS toe.

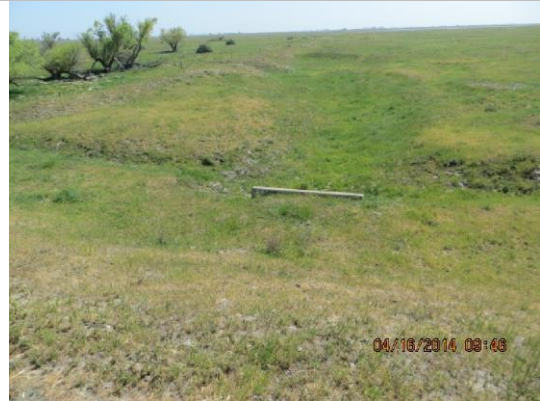
Photo 3 of 3 : UCIP\_SP\_2017\_33752\_61074.jpg

Pipe and headwall on LS toe.

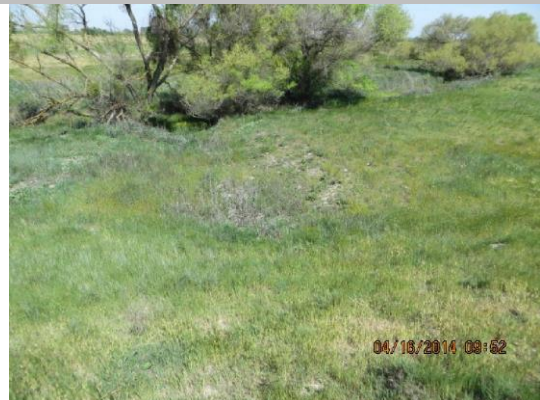
Photo 1 of 3 : UCIP\_SP\_2017\_33753\_61078.jpg

LM Start	0.72	Rating **	A/W	Issue No.	24
LM End	0.72	Issue Type +	Ma	Location *	WS
Category	Supplemental			GPS Latitude/Longitude	
				Start	End
Item	DWR UCIP LMA Responsibility			37.260306 °	37.260306 °
				-120.762127 °	-120.762127 °
DWR ID					
Comment Code					
Inspector Comment					
FS_ID:33753 DS_ID:19905 EP_NO: N/A Repair Type: No Action Needed Crossing Status: Found UCIP Comments: FIELD_STRUCT_DESC: 24-inch CM stormdrain pipe through levee, 10.0-feet below crown. Flap gate on the waterward end. Concrete headwall on both ends. (USACE-1967). This entry matches the Drainage or Irrigation Structure referenced in O&M manual (HLM 0.72). FS Date: 4/16/2014

Headwall and flapgate at WS toe.

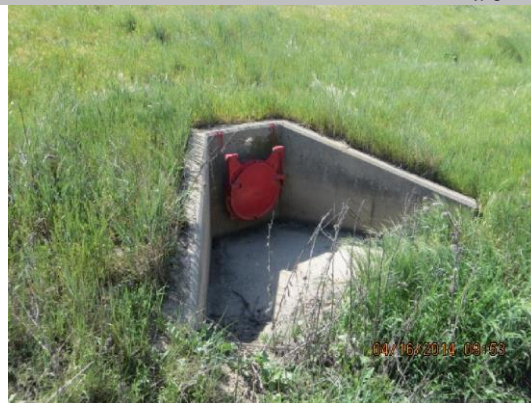
Photo 2 of 3 : UCIP\_SP\_2017\_33753\_61080.jpg

Headwall and flapgate at WS toe.

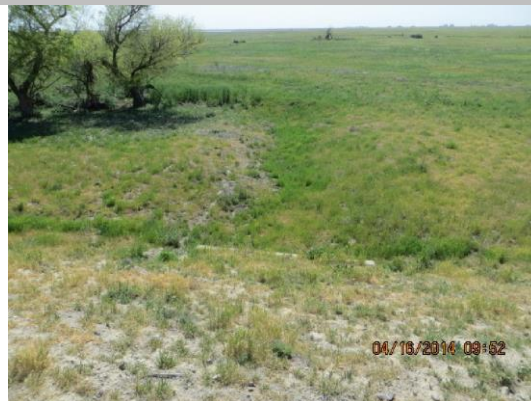
Photo 3 of 3 : UCIP\_SP\_2017\_33753\_61079.jpg

Concrete headwall on LS toe.

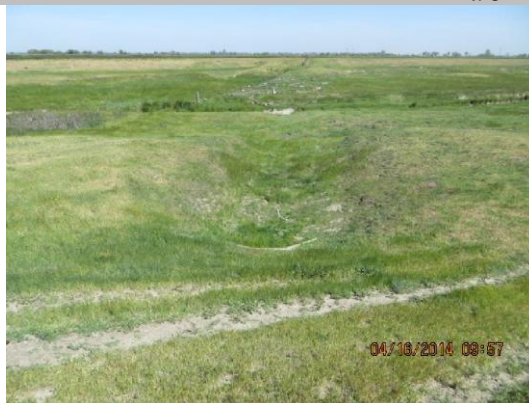
Photo 1 of 3 : UCIP\_SP\_2017\_39887\_61084.jpg

LM Start	0.90	Rating **	M	Issue No.	25
LM End	0.90	Issue Type +	Ma	Location *	WS
Category	Supplemental			GPS Latitude/Longitude	
				Start	End
Item	DWR UCIP LMA Responsibility			37.262384 °	37.262384 °
				-120.760528 °	-120.760528 °
DWR ID					
Comment Code					
Inspector Comment					
FS_ID:39887 DS_ID:19832 EP_NO: N/A Repair Type: Non-Urgent Crossing Status: Found UCIP Comments: Some sediment buildup at inlet on LS toe. FIELD_STRUCT_DESC: 24-inch CM stormdrain pipe through levee, 11.5 feet below crown. Flap gate on the waterward end. Concrete headwalls. (USACE-1967). This entry matches the Drainage or Irrigation Structure referenced in O&M manual (HLM 0.89). FS Date: 4/16/2014

Headwall, pipe, and flapgate on WS toe.

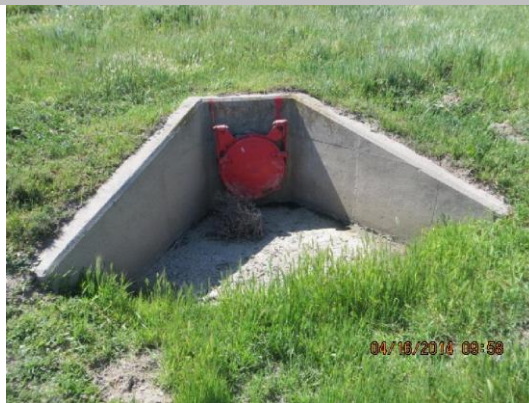
Photo 2 of 3 : UCIP\_SP\_2017\_39887\_61083.jpg

Headwall, pipe, and flapgate on WS toe.

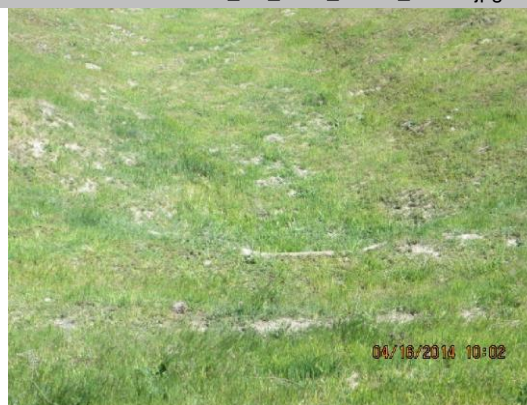
Photo 1 of 3 : UCIP\_SP\_2017\_39509\_61090.jpg

LM Start	1.21	Rating **	M	Issue No.	26
LM End	1.21	Issue Type +	Ma	Location *	LS
Category	Supplemental			GPS Latitude/Longitude	
				Start	End
Item	DWR UCIP LMA Responsibility			37.263188 °	37.263188 °
				-120.755399 °	-120.755399 °
DWR ID					
Comment Code					
Inspector Comment					
FS_ID:39509 DS_ID:19833 EP_NO: N/A Repair Type: Non-Urgent Crossing Status: Found UCIP Comments: Debris blocking landward headwall--recommend clearing. FIELD_STRUCT_DESC: 24-inch CM stormdrain pipe through levee, 11.6 feet below crown. Flap gate on the waterward end. Concrete headwalls. (USACE-1967). This entry matches the Drainage or Irrigation Structure referenced in O&M manual (HLM 1.21). FS Date: 4/16/2014

Concrete headwall, pipe, and flapgate on WS toe.

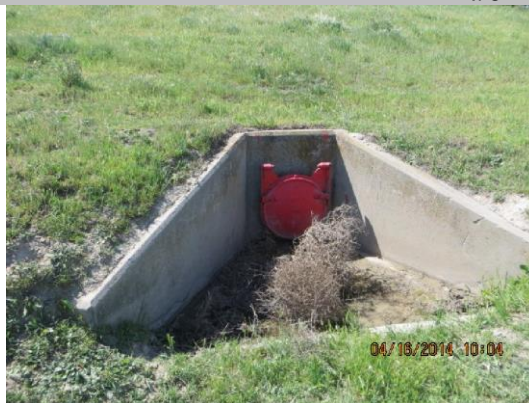
Photo 2 of 3 : UCIP\_SP\_2017\_39509\_61091.jpg

Concrete headwall, pipe, and flapgate on WS toe.

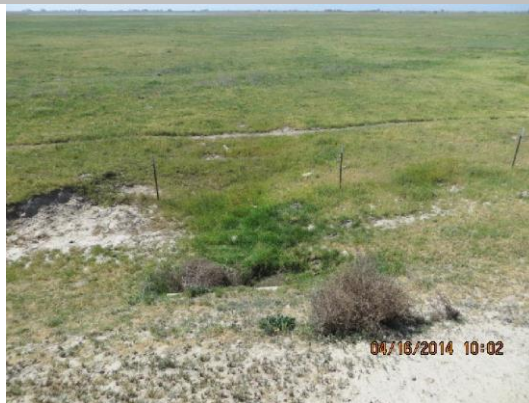
Photo 3 of 3 : UCIP\_SP\_2017\_39509\_61089.jpg

Pipe and headwall on LS toe.

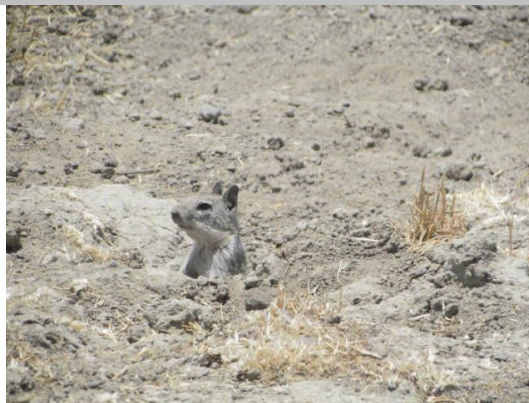
Photo 1 of 1 : SP\_2017\_NA0010\_126\_8\_20170417\_00004.jpg

LM Start	1.38	Rating **	M	Issue No.	8
LM End	1.38	Issue Type +	Ma	Location *	LS
Category	Earthen Levee			GPS Latitude/Longitude	
				Start	End
Item	Animal Control			37.263175 °	37.263175 °
				-120.752307 °	-120.752307 °
DWR ID	DWR_NA0010_08_s _ 2013_8				
Comment Code					
A1 : Exterminate rodents and backfill and compact or grout burrows.					
Inspector Comment

Looking west at rodent holes on landward slope.

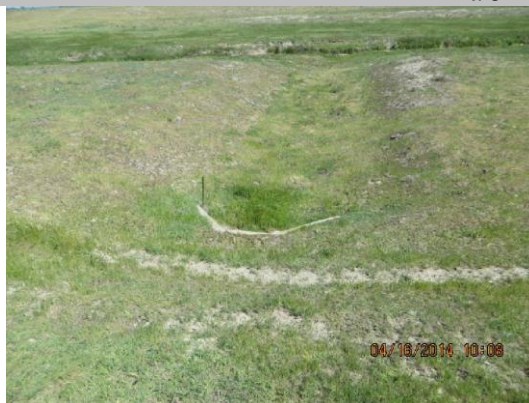
Photo 1 of 3 : UCIP\_SP\_2017\_39510\_61094.jpg

LM Start	1.38	Rating **	M	Issue No.	27
LM End	1.38	Issue Type +	Ma	Location *	LS
Category	Supplemental			GPS Latitude/Longitude	
				Start	End
Item	DWR UCIP LMA Responsibility			37.263194 °	37.263194 °
				-120.752299 °	-120.752299 °
DWR ID					
Comment Code					
Inspector Comment					
FS_ID:39510 DS_ID:19834 EP_NO: N/A Repair Type: Non-Urgent Crossing Status: Found UCIP Comments: Animal burrows along pipe alignment on LS. Some sediment buildup at LS toe and inside pipe--recommend clearing. FIELD_STRUCT_DESC: 24-inch CM stormdrain pipe through levee, 11.5 feet below crown. Flap gate on the waterward end. Concrete headwall on both ends. (USACE-1967). This entry matches the Drainage or Irrigation Structure referenced in O&M manual (HLM 1.38). FS Date: 4/16/2014

Pipe, headwall, and flapgate on WS toe.

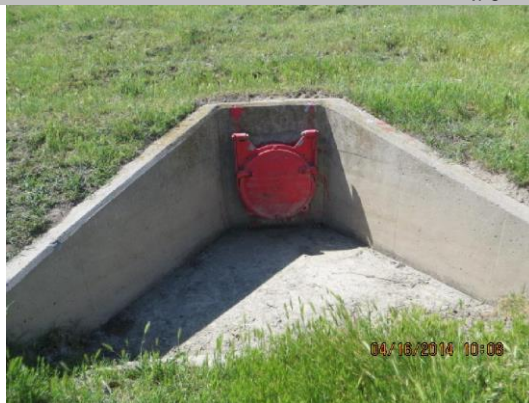
Photo 2 of 3 : UCIP\_SP\_2017\_39510\_61093.jpg

Pipe, headwall, and flapgate on WS toe.

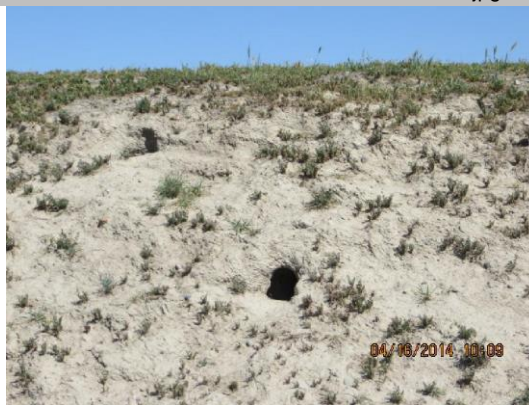
Photo 3 of 3 : UCIP\_SP\_2017\_39510\_61095.jpg

Animal burrows along alignment on LS slope.

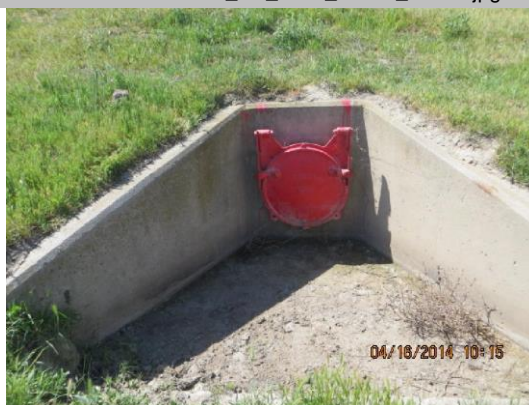
Photo 1 of 3 : UCIP\_SP\_2017\_39511\_61098.jpg

LM Start	2.05	Rating **	M	Issue No.	28
LM End	2.05	Issue Type +	Ma	Location *	WS
Category	Supplemental			GPS Latitude/Longitude	
				Start	End
Item	DWR UCIP LMA Responsibility			37.258220 °	37.258220 °
				-120.742868 °	-120.742868 °
DWR ID					
Comment Code					
Inspector Comment					
FS_ID:39511 DS_ID:19835 EP_NO: N/A Repair Type: Non-Urgent Crossing Status: Found UCIP Comments: Non-functional landward inlet is buried in sediment. Need to contact owner to determine status. FIELD_STRUCT_DESC: 24-inch CM stormdrain pipe through levee, 12.0 feet below crown. Flap gate on the waterward end. Concrete headwall on both ends. (USACE-1967). This entry matches the Drainage or Irrigation Structure referenced in O&M manual (HLM 2.05). FS Date: 4/16/2014

Pipe, headwall, and flapgate on Ws toe.

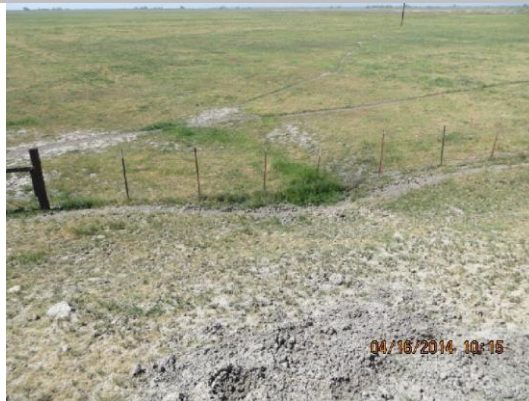
Photo 2 of 3 : UCIP\_SP\_2017\_39511\_61099.jpg

Pipe and headwall buried in sediment at LS toe.

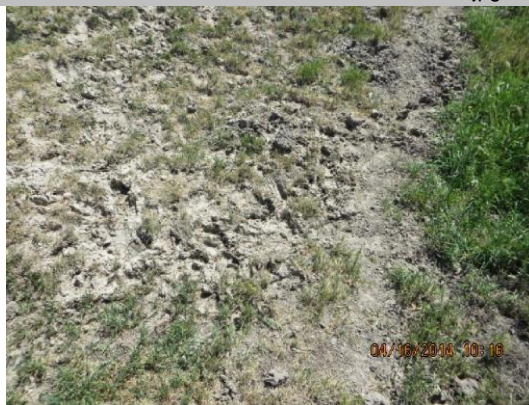
Photo 3 of 3 : UCIP\_SP\_2017\_39511\_61097.jpg

Pipe and headwall buried in sediment at LS toe.

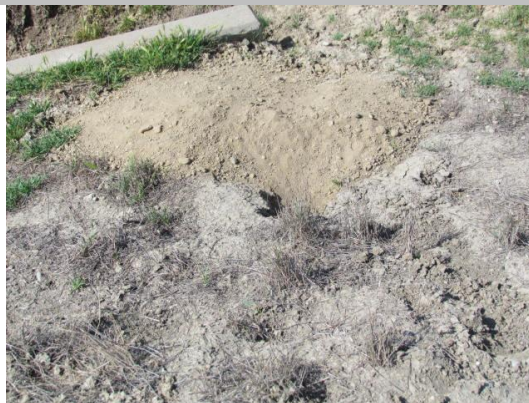
Photo 1 of 1 : SP\_2017\_NA0010\_126\_7\_20170417\_00003.jpg

LM Start	2.07	Rating **	M	Issue No.	7
LM End	2.13	Issue Type +	Ma	Location *	LS
Category	Earthen Levee			GPS Latitude/Longitude	
				Start	End
Item	Animal Control			37.258063 °	37.257688 °
				-120.742460 °	-120.741573 °
DWR ID	DWR_NA0010_08_s_2012_7				
Comment Code					
A1 : Exterminate rodents and backfill and compact or grout burrows.					
Inspector Comment					
No rodent activity and no rodent holes noted.

Looking at typical rodent hole on landside slope near headwall.

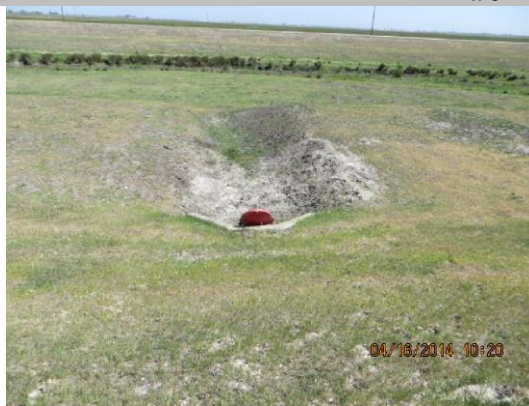
Photo 1 of 3 : UCIP\_SP\_2017\_39512\_61102.jpg

LM Start	2.12	Rating **	M	Issue No.	29
LM End	2.12	Issue Type +	Ma	Location *	LS
Category	Supplemental			GPS Latitude/Longitude	
				Start	End
Item	DWR UCIP LMA Responsibility			37.257800 °	37.257800 °
				-120.741604 °	-120.741604 °
DWR ID					
Comment Code					
Inspector Comment					
FS_ID:39512 DS_ID:19836 EP_NO: N/A Repair Type: Non-Urgent Crossing Status: Found UCIP Comments: Sediment buildup in pipe visible from landward side. FIELD_STRUCT_DESC: 24-inch CM stormdrain pipe through levee, 9.5- feet below crown. Flap gate on the waterward end. Concrete headwall on both ends. (USACE-1967). This entry matches the Drainage or Irrigation Structure referenced in O&M manual (HLM 2.12). FS Date: 4/16/2014

Pipe, headwall, and flapgate on WS toe.

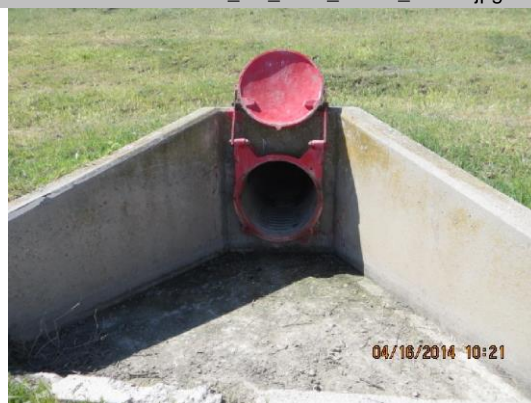
Photo 2 of 3 : UCIP\_SP\_2017\_39512\_61100.jpg

Pipe, headwall, and flapgate on WS toe.

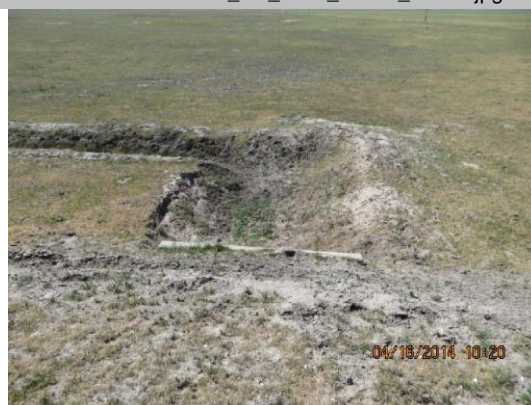
Photo 3 of 3 : UCIP\_SP\_2017\_39512\_61101.jpg

Pipe and headwall on LS toe.

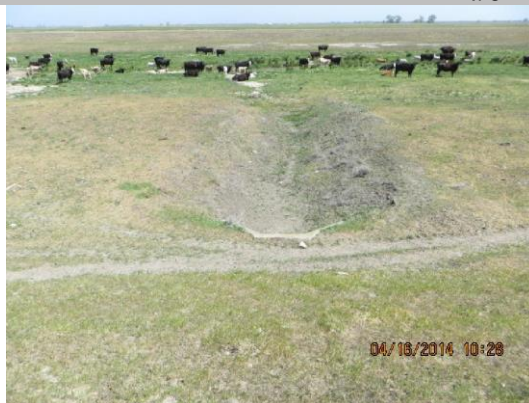
Photo 1 of 3 : UCIP\_SP\_2017\_33760\_61107.jpg

LM Start	2.77	Rating **	A/W	Issue No.	30
LM End	2.77	Issue Type +	Ma	Location *	LS
Category	Supplemental			GPS Latitude/Longitude	
				Start	End
Item	DWR UCIP LMA Responsibility			37.252228 °	37.252228 °
				-120.732890 °	-120.732890 °
DWR ID					
Comment Code					
Inspector Comment					
FS_ID:33760					
DS_ID:19837					
EP_NO: N/A					
Repair Type: No Action Needed					
Crossing Status: Found					
UCIP Comments:					
FIELD_STRUCT_DESC: 24-inch CM stormdrain pipe through levee,					
10.5 feet below crown. Flap gate on the waterward end. Concrete					
headwall on both ends. (USACE-1967). This entry matches the					
Drainage or Irrigation Structure referenced in O&M manual (HLM 2.77).					
FS Date: 4/16/2014

Pipe, headwall, and flapgate on Ws toe.

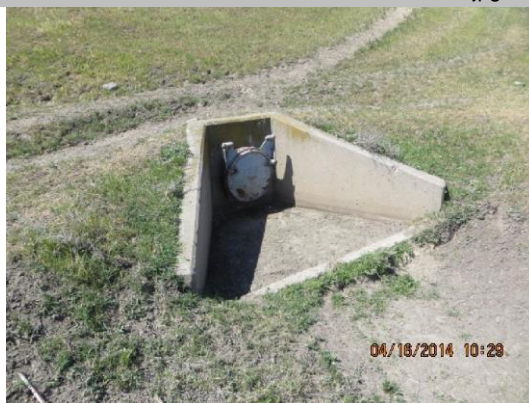
Photo 2 of 3 : UCIP\_SP\_2017\_33760\_61105.jpg

Pipe, headwall, and flapgate on Ws toe.

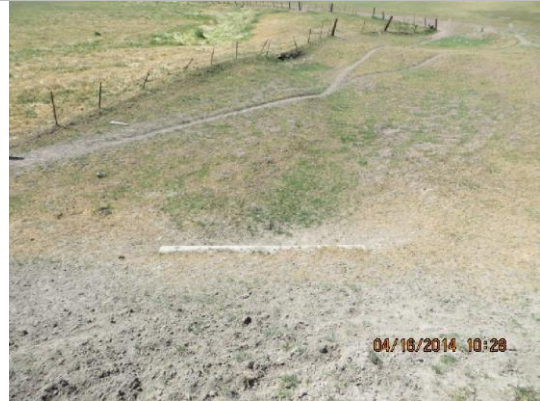
Photo 3 of 3 : UCIP\_SP\_2017\_33760\_61106.jpg

Pipe and headwall on LS toe.

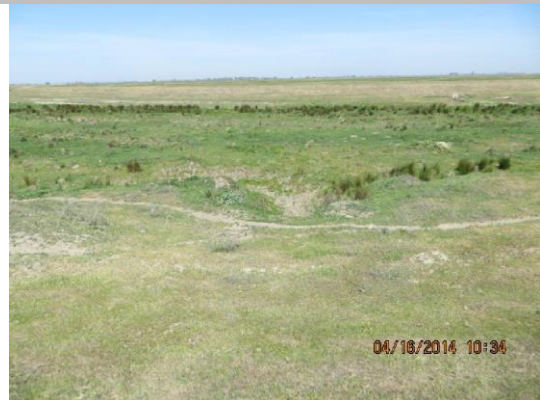
Photo 1 of 3 : UCIP\_SP\_2017\_49969\_61112.jpg

Comment Code					
Inspector Comment					
FS_ID:49969 DS_ID:19838 EP_NO: N/A Repair Type: Non-Urgent Crossing Status: Found UCIP Comments: 7/20/2016 LS inlet buried under dense vegetation. Dense vegetation limits the inspector's visibility to identify signs of pipe failure (leaks) along the WS and LS slope. Recommend removing vegetation along pipe alignment to conduct proper inspection of structure and appurtenances. (DWR UCIP - omagana)4/16/2014 Pipe blocked by silt on LS toe. Flapgate rusty and does not operate correctly. (DWR UCIP - omagana) FIELD_STRUCT_DESC: 36-inch corrugated metal drainage pipe through levee, 13.4 feet below crown. Flap gate located on the waterside (WS) end. Concrete headwall located on the landside (LS). [Additional Reference(s): DWR Levee Log, 2002. USACE San Joaquin O&M Manuals: Unit No. 601, 1967, (HLM 3.06), Unit No. 601 Part I, 1967 (Amended in 1978), Unit No. 601 Part II, 1969, and Unit No. 601 Part III, 1969] FS Date: 7/20/2016

Pipe, headwall, and flapgate on WS toe.

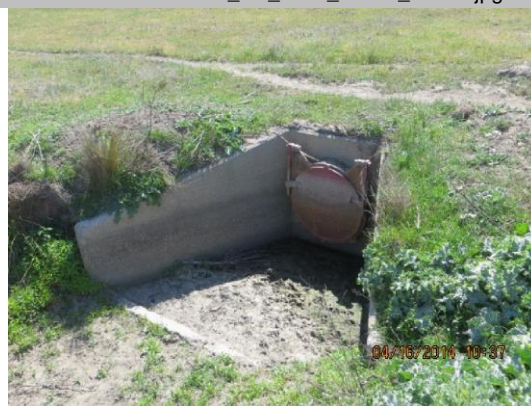
Photo 2 of 3 : UCIP\_SP\_2017\_49969\_61113.jpg

Pipe, headwall, and flapgate on WS toe.

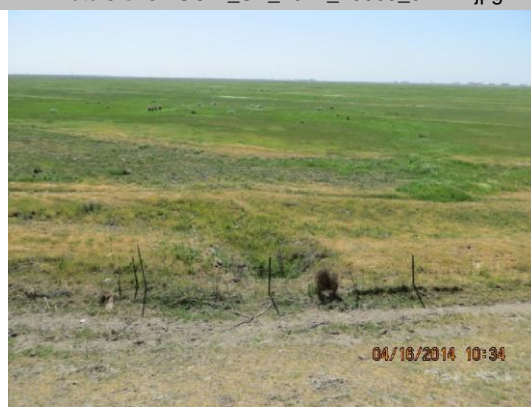
Photo 3 of 3 : UCIP\_SP\_2017\_49969\_61111.jpg

FS\_ID:49969  
DS\_ID:19838  
EP\_NO: N/A  
Repair Type: Non-Urgent  
Crossing Status: Found  
UCIP Comments: 7/20/2016 LS inlet buried under dense vegetation. Dense vegetation limits the inspector's visibility to identify signs of pipe failure (leaks) along the WS and LS slope. Recommend removing vegetation along pipe alignment to conduct proper inspection of structure and appurtenances. (DWR UCIP - omagana)4/16/2014 Pipe blocked by silt on LS toe. Flapgate rusty and does not operate correctly. (DWR UCIP - omagana)  
FIELD\_STRUCT\_DESC: 36-inch corrugated metal drainage pipe through levee, 13.4 feet below crown. Flap gate located on the waterside (WS) end. Concrete headwall located on the landside (LS).  
[Additional Reference(s): DWR Levee Log, 2002. USACE San Joaquin O&M Manuals: Unit No. 601, 1967, (HLM 3.06), Unit No. 601 Part I, 1967 (Amended in 1978), Unit No. 601 Part II, 1969, and Unit No. 601 Part III, 1969]

Pipe and headwall on LS toe.
