**Flood Control Project Maintenance  
Levee Inspections**  
**LMA District Cover Sheet**  
**Spring 2017 Levee Inspection Results**

**Lower San Joaquin Levee District**

Waterway			Bank	Unit Miles
Unit No. 01 San Joaquin River			Right	22.52
	Spring (March - May)	Summer (June - August)	(September - November) Fall	Winter (December - February)
Unit Maintenance Rating (Fall Only)				
Date of Inspection	4/17/2017 - 4/20/2017			
DWR Inspector	Richard Willoughby			
Accompanied By

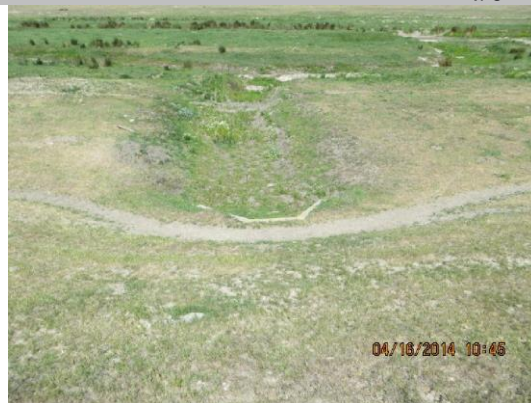
Photo 1 of 3 : UCIP\_SP\_2017\_33764\_61128.jpg

FS\_ID:33764  
DS\_ID:19839  
EP\_NO: N/A  
Repair Type: No Action Needed  
Crossing Status: Found  
UCIP Comments:  
FIELD\_STRUCT\_DESC: 24-inch CM stormdrain pipe through levee, 10.0 feet below crown. Flap gate on the waterward end. Concrete headwall on both ends. (USACE-1967). This entry matches the Drainage or Irrigation Structure referenced in O&M manual (HLM 3.24).  
FS Date: 4/16/2014

Pipe, flapgate, and headwall on WS toe.

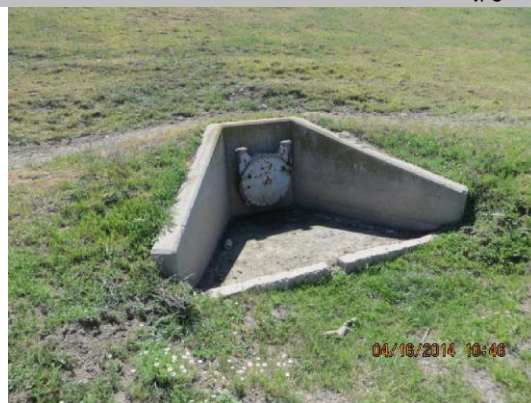
Photo 2 of 3 : UCIP\_SP\_2017\_33764\_61127.jpg

Pipe, flapgate, and headwall on WS toe.

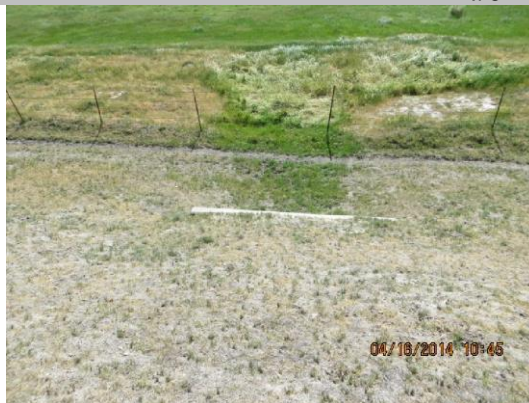
Photo 3 of 3 : UCIP\_SP\_2017\_33764\_61129.jpg

Pipe and headwall on LS toe.

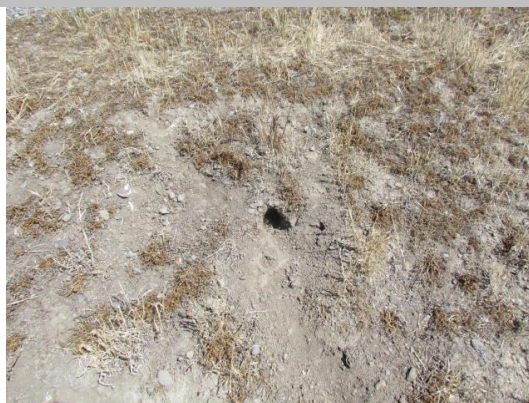
Photo 1 of 1 : SP\_2017\_NA0010\_126\_3\_20170417\_00001.jpg

LM Start	3.40	Rating **	M	Issue No.	3
LM End	3.54	Issue Type +	Ma	Location *	LS
Category	Earthen Levee			GPS Latitude/Longitude	
				Start	End
Item	Animal Control			37.253052 °	37.253600 °
				-120.722647 °	-120.720198 °
DWR ID	DWR_NA0010_08_s_2012_3				
Comment Code					
A3 : No rodents visible, but rodent burrows visible; need to backfill and compact or grout burrows.					
Inspector Comment					
Noted several rodent holes on landward slope within this reach.

Looking at typical view of rodent holes on landward slope.

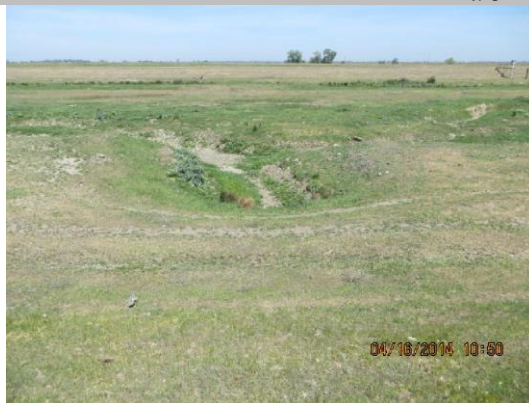
Photo 1 of 3 : UCIP\_SP\_2017\_39513\_61134.jpg

LM Start	3.43	Rating **	M	Issue No.	33
LM End	3.43	Issue Type +	Ma	Location *	LS
Category	Supplemental			GPS Latitude/Longitude	
				Start	End
Item	DWR UCIP LMA Responsibility			37.253151 °	37.253151 °
				-120.722182 °	-120.722182 °
DWR ID					
Comment Code					
Inspector Comment					
FS_ID:39513 DS_ID:19840 EP_NO: N/A Repair Type: Non-Urgent Crossing Status: Found UCIP Comments: No access available on landward side. Need to confirm status of crossing. FIELD_STRUCT_DESC: 24-inch CM stormdrain pipe through levee, 13.0 feet below crown. Flap gate on the waterward end. Concrete headwall on both ends. (USACE-1967). This entry matches the Drainage or Irrigation Structure referenced in O&M manual (HLM 3.43). FS Date: 4/16/2014

Pipe, headwall, and flapgate on WS toe.

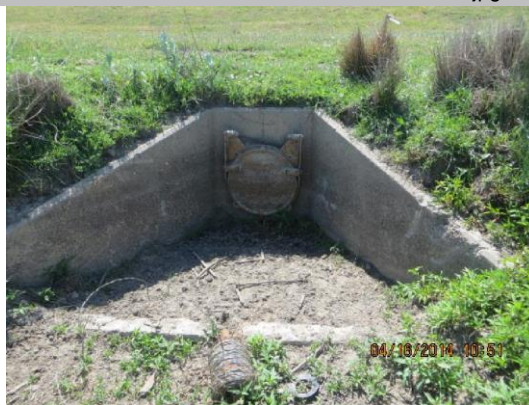
Photo 2 of 3 : UCIP\_SP\_2017\_39513\_61133.jpg

Pipe, headwall, and flapgate on WS toe.

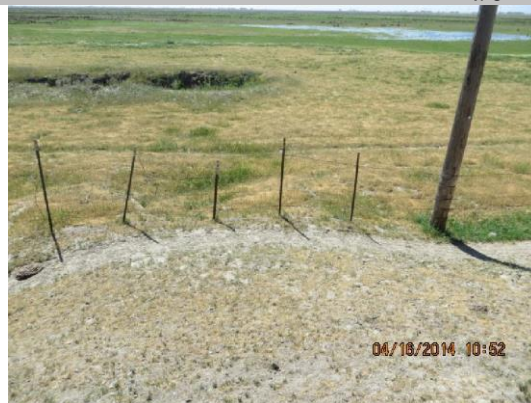
Photo 3 of 3 : UCIP\_SP\_2017\_39513\_61132.jpg

LM Start	3.43	Rating **	M	Issue No.	33 (cont)
LM End	3.43	Issue Type +	Ma	Location *	LS
Category	Supplemental			GPS Latitude/Longitude	
				Start	End
Item	DWR UCIP LMA Responsibility			37.253151 °	37.253151 °
				-120.722182 °	-120.722182 °
DWR ID					
Comment Code					
Inspector Comment					
FS_ID:39513 DS_ID:19840 EP_NO: N/A Repair Type: Non-Urgent Crossing Status: Found UCIP Comments: No access available on landward side. Need to confirm status of crossing. FIELD_STRUCT_DESC: 24-inch CM stormdrain pipe through levee, 13.0 feet below crown. Flap gate on the waterward end. Concrete headwall on both ends. (USACE-1967). This entry matches the Drainage or Irrigation Structure referenced in O&M manual (HLM 3.43). FS Date: 4/16/2014

Pipe likely at drainage swale off LS toe.

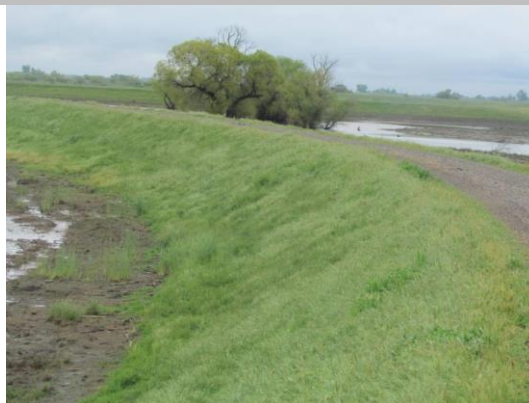
Photo 1 of 1 : SP\_2017\_NA0010\_127\_4\_20170425\_00012.jpg

LM Start	0.00	Rating **	M	Issue No.	4
LM End	0.87	Issue Type +	Ma	Location *	LS
Category	Earthen Levee			GPS Latitude/Longitude	
				Start	End
Item	Vegetation			37.220282 °	37.220058 °
				-120.713077 °	-120.698240 °
DWR ID	DWR_NA0010_09_s_2017_4				
Comment Code					
V1 : Control annual grass and weeds on the levee slopes and easements.					
Inspector Comment

Looking at typical view of landward slope.

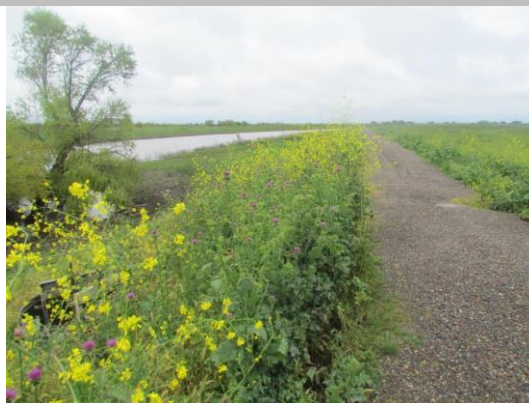
Photo 1 of 1 : SP\_2017\_NA0010\_127\_6\_20170425\_00011.jpg

LM Start	0.00	Rating **	U	Issue No.	6
LM End	0.87	Issue Type +	Ma	Location *	WS
Category	Earthen Levee			GPS Latitude/Longitude	
				Start	End
Item	Vegetation			37.220282 °	37.220058 °
				-120.713077 °	-120.698240 °
DWR ID	DWR_NA0010_09_s_2017_6				
Comment Code					
V1 : Control annual grass and weeds on the levee slopes and easements.					
Inspector Comment

Looking downstream at dense veg on waterward slope.

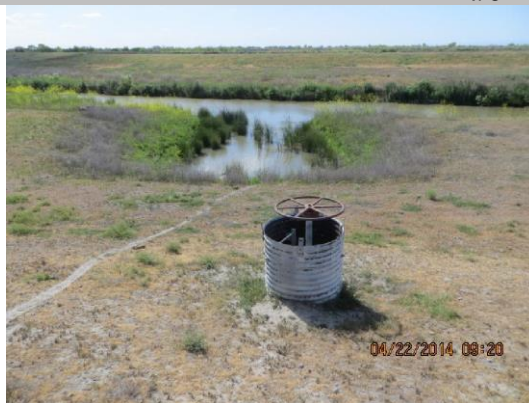
Photo 1 of 3 : UCIP\_SP\_2017\_39888\_62119.jpg

LM Start	0.47	Rating **	M	Issue No.	7
LM End	0.47	Issue Type +	Ma	Location *	WS
Category	Supplemental			GPS Latitude/Longitude	
				Start	End
Item	DWR UCIP LMA Responsibility			37.220416 °	37.220416 °
				-120.705248 °	-120.705248 °
DWR ID					
Comment Code					
Inspector Comment					
FS_ID:39888 DS_ID:19841 EP_NO: N/A Repair Type: Non-Urgent Crossing Status: Found UCIP Comments: Concrete headwalls on landward and waterward under water. Need photo to confirm condition of concrete headwalls, pipe, and gate on both toes. FIELD_STRUCT_DESC: 24-inch C.M. stormdrain pipe through the levee, 18.7-feet below the crown. Slide gate inside 36-inch C.M. pipe riser on the waterward slope. Concrete "U" headwalls on both ends. (USACE-1967). This entry matches the Drainage or Irrigation Structure referenced in O&M manual (HLM 0.47). FS Date: 4/22/2014

Slide gate in CMP riser on WS slope with outlet visible in background.

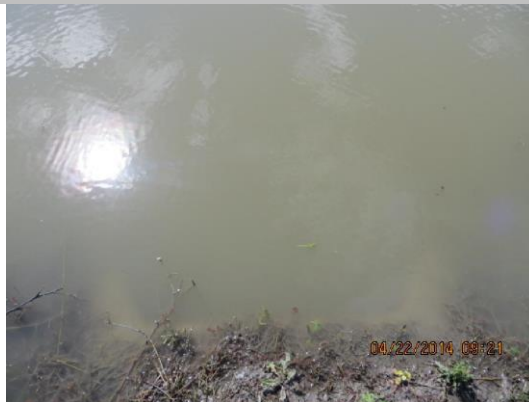
Photo 2 of 3 : UCIP\_SP\_2017\_39888\_62117.jpg

Concrete headwall visible under water on WS toe.

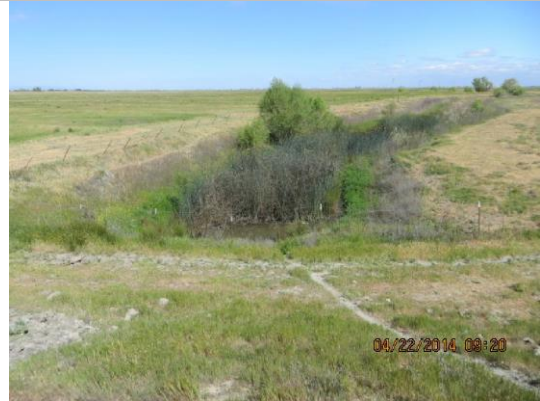
Photo 3 of 3 : UCIP\_SP\_2017\_39888\_62118.jpg

LM Start	0.47	Rating **	M	Issue No.	7 (cont)	
LM End	0.47	Issue Type +	Ma	Location *	WS	
Category	Supplemental			GPS Latitude/Longitude		
				Start	End	
Item	DWR UCIP LMA Responsibility			37.220416°	37.220416°	
				-120.705248°	-120.705248°	
DWR ID						
Comment Code						
Inspector Comment						
FS_ID:39888 DS_ID:19841 EP_NO: N/A Repair Type: Non-Urgent Crossing Status: Found UCIP Comments: Concrete headwalls on landward and waterward under water. Need photo to confirm condition of concrete headwalls, pipe, and gate on both toes. FIELD_STRUCT_DESC: 24-inch C.M. stormdrain pipe through the levee, 18.7-feet below the crown. Slide gate inside 36-inch C.M. pipe riser on the waterward slope. Concrete "U" headwalls on both ends. (USACE-1967). This entry matches the Drainage or Irrigation Structure referenced in O&M manual (HLM 0.47). FS Date: 4/22/2014

Concrete headwall visible at inlet on LS toe.

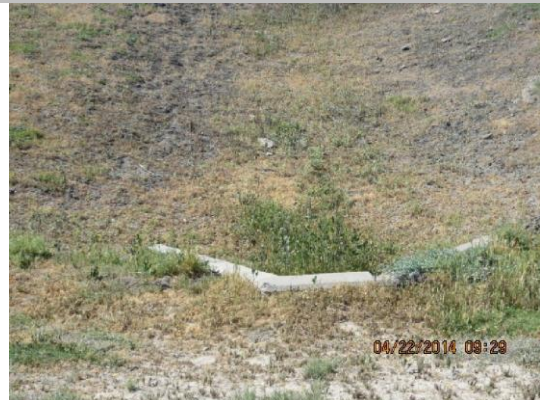
Photo 1 of 3 : UCIP\_SP\_2017\_39515\_62128.jpg

LM Start	0.69	Rating **	M	Issue No.	8
LM End	0.69	Issue Type +	Ma	Location *	WS
Category	Supplemental			GPS Latitude/Longitude	
				Start	End
Item	DWR UCIP LMA Responsibility			37.219874 °	37.219874 °
				-120.701438 °	-120.701438 °
DWR ID					
Comment Code					
Inspector Comment					
FS_ID:39515 DS_ID:19842 EP_NO: N/A Repair Type: Non-Urgent Crossing Status: Found UCIP Comments: Animal burrows in area on LS slope. Minor sediment buildup in pipe visible on landward side--recommend clearing. FIELD_STRUCT_DESC: 24-inch C.M. stormdrain pipe through the levee, 8.7-feet below the crown. Flap gate on the waterward end. Concrete headwall on the landward end. Concrete "U" headwall on the waterward end. (USACE-1967). This entry matches the Drainage or Irrigation Structure referenced in O&M manual (HLM 0.70). FS Date: 4/22/2014

Headwall, flapgate, and pipe on WS toe.

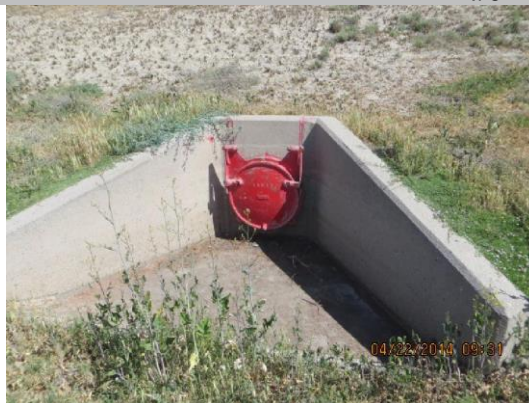
Photo 2 of 3 : UCIP\_SP\_2017\_39515\_62132.jpg

LM Start	0.69	Rating **	M	Issue No.	8 (cont)	
LM End	0.69	Issue Type +	Ma	Location *	WS	
Category	Supplemental			GPS Latitude/Longitude		
				Start		End
Item	DWR UCIP LMA Responsibility			37.219874 °	37.219874 °	
				-120.701438 °	-120.701438 °	
DWR ID						
Comment Code						
Inspector Comment						
FS_ID:39515 DS_ID:19842 EP_NO: N/A Repair Type: Non-Urgent Crossing Status: Found UCIP Comments: Animal burrows in area on LS slope. Minor sediment buildup in pipe visible on landward side--recommend clearing. FIELD_STRUCT_DESC: 24-inch C.M. stormdrain pipe through the levee, 8.7-feet below the crown. Flap gate on the waterward end. Concrete headwall on the landward end. Concrete "U" headwall on the waterward end. (USACE-1967). This entry matches the Drainage or Irrigation Structure referenced in O&M manual (HLM 0.70). FS Date: 4/22/2014

Headwall, flapgate, and pipe on WS toe.

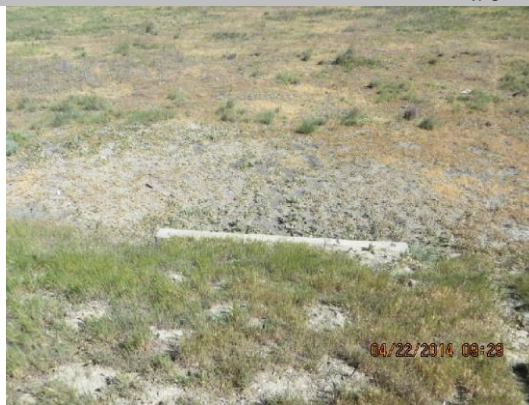
Photo 3 of 3 : UCIP\_SP\_2017\_39515\_62129.jpg

Headwall and pipe on LS toe.

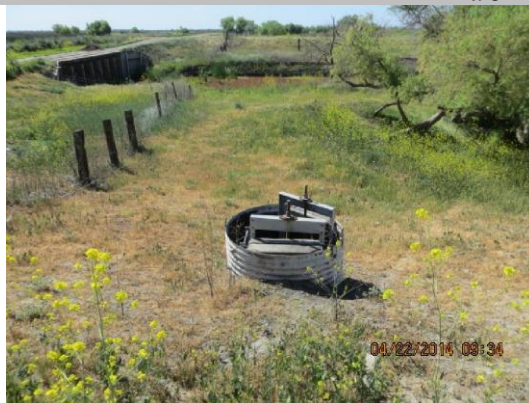
Photo 1 of 3 : UCIP\_SP\_2017\_34186\_62134.jpg

LM Start	0.87	Rating **	A/W	Issue No.	9
LM End	0.87	Issue Type +	Ma	Location *	WS
Category	Supplemental			GPS Latitude/Longitude	
				Start	End
Item	DWR UCIP LMA Responsibility			37.220051 °	37.220051 °
				-120.698374 °	-120.698374 °
DWR ID					
Comment Code					
Inspector Comment					
FS_ID:34186 DS_ID:19843 EP_NO: N/A Repair Type: No Action Needed Crossing Status: Found UCIP Comments: FIELD_STRUCT_DESC: 24-inch C.M. stormdrain pipe through levee, 9.7-feet below crown. Two slide gates in 48-inch C.M. pipe riser on the waterward slope. Concrete "U" headwall on landward end. Waterward end cobble revetted on bank and in outlet drain. This entry matches the Drainage or Irrigation Structure referenced in O&M manual (HLM 0.87). FS Date: 4/22/2014

48-inch CMP riser with slide gates on WS slope.

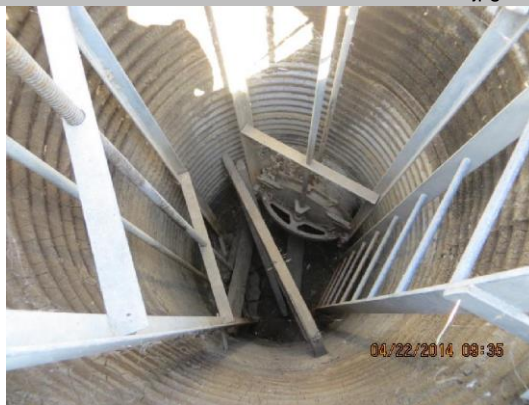
Photo 2 of 3 : UCIP\_SP\_2017\_34186\_62133.jpg

Inside CMP riser on WS slope.

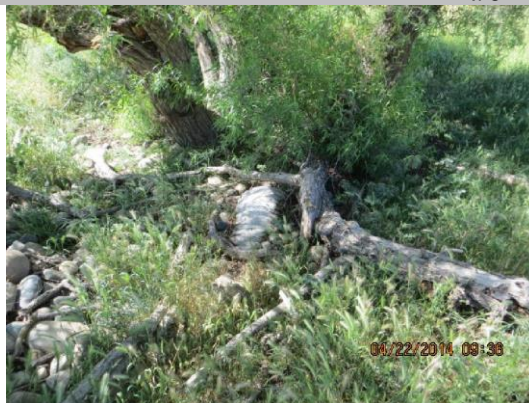
Photo 3 of 3 : UCIP\_SP\_2017\_34186\_62137.jpg

LM Start	0.87	Rating **	A/W	Issue No.	9 (cont)	
LM End	0.87	Issue Type +	Ma	Location *	WS	
Category	Supplemental			GPS Latitude/Longitude		
				Start		End
Item	DWR UCIP LMA Responsibility			37.220051 °		37.220051 °
				-120.698374 °		-120.698374 °
DWR ID						
Comment Code						
Inspector Comment						
FS_ID:34186 DS_ID:19843 EP_NO: N/A Repair Type: No Action Needed Crossing Status: Found UCIP Comments: FIELD_STRUCT_DESC: 24-inch C.M. stormdrain pipe through levee, 9.7-feet below crown. Two slide gates in 48-inch C.M. pipe riser on the waterward slope. Concrete "U" headwall on landward end. Waterward end cobble revetted on bank and in outlet drain. This entry matches the Drainage or Irrigation Structure referenced in O&M manual (HLM 0.87). FS Date: 4/22/2014

Outlet at WS toe.

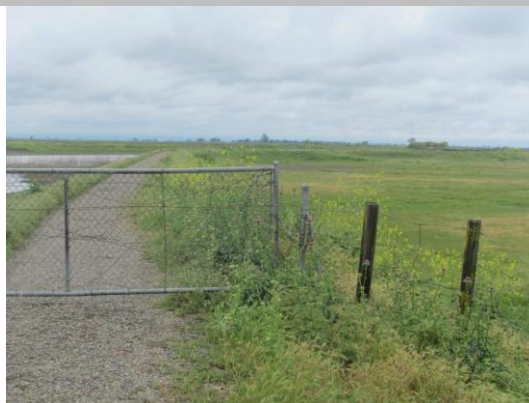
Photo 1 of 1 : SP\_2017\_NA0010\_128\_3\_20170425\_00004.jpg

LM Start	0.00	Rating **	M	Issue No.	3
LM End	0.79	Issue Type +	Ma	Location *	LS
Category	Earthen Levee			GPS Latitude/Longitude	
				Start	End
Item	Vegetation			37.217905 °	37.219367 °
				-120.711465 °	-120.698023 °
DWR ID	DWR_NA0010_10_s_2017_3				
Comment Code					
V1 : Control annual grass and weeds on the levee slopes and easements.					
Inspector Comment

Looking downstream at typical view of landward slope.

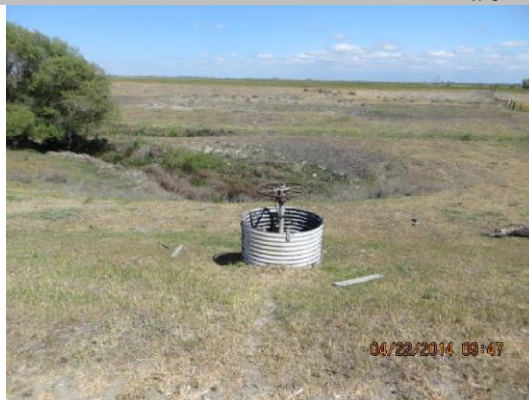
Photo 1 of 3 : UCIP\_SP\_2017\_39516\_62144.jpg

LM Start	0.30	Rating **	M	Issue No.	4
LM End	0.30	Issue Type +	Ma	Location *	LS
Category	Supplemental			GPS Latitude/Longitude	
				Start	End
Item	DWR UCIP LMA Responsibility			37.219116 °	37.219116 °
				-120.706652 °	-120.706652 °
DWR ID					
Comment Code					
Inspector Comment					
FS_ID:39516 DS_ID:19845 EP_NO: N/A Repair Type: Non-Urgent Crossing Status: Found UCIP Comments: Inlet blocked at LS toe by wooden gate. Need to contact owner to determine status. FIELD_STRUCT_DESC: 36-inch CM stormdrain pipe through levee, 19.6-feet below crown. Slide gate in 48-inch CM pipe riser on the waterward slope. Concrete "U" headwalls on both ends. (USACE-1967). This entry matches the Drainage or Irrigation Structure referenced in O&M manual (HLM 0.31). FS Date: 4/22/2014

Headwall and pipe visible on LS toe. Slide gate inside 48-inch CMP riser on WS slope.

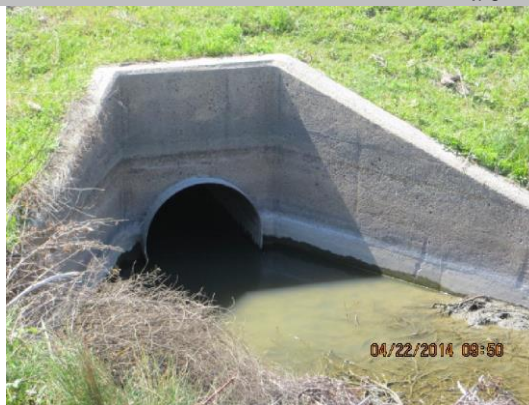
Photo 2 of 3 : UCIP\_SP\_2017\_39516\_62146.jpg

Headwall and pipe on WS toe.

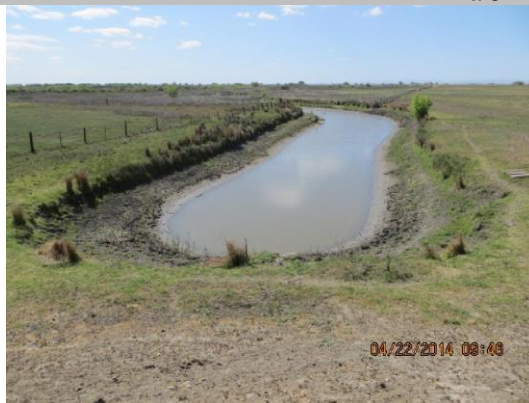
Photo 3 of 3 : UCIP\_SP\_2017\_39516\_62145.jpg

LM Start	0.30	Rating **	M	Issue No.	4 (cont)	
LM End	0.30	Issue Type +	Ma	Location *	LS	
Category	Supplemental			GPS Latitude/Longitude		
				Start		End
Item	DWR UCIP LMA Responsibility			37.219116 °		37.219116 °
				-120.706652 °		-120.706652 °
DWR ID						
Comment Code						
Inspector Comment						
FS_ID:39516 DS_ID:19845 EP_NO: N/A Repair Type: Non-Urgent Crossing Status: Found UCIP Comments: Inlet blocked at LS toe by wooden gate. Need to contact owner to determine status. FIELD_STRUCT_DESC: 36-inch CM stormdrain pipe through levee, 19.6-feet below crown. Slide gate in 48-inch CM pipe riser on the waterward slope. Concrete "U" headwalls on both ends. (USACE-1967). This entry matches the Drainage or Irrigation Structure referenced in O&M manual (HLM 0.31). FS Date: 4/22/2014

Headwall and pipe on LS toe. Pipe blocked by wooden cover.

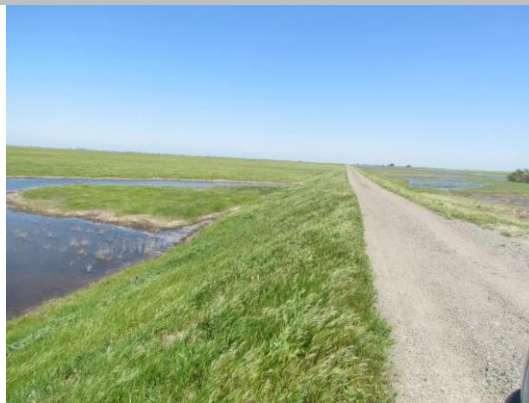
Photo 1 of 1 : SP\_2017\_NA0010\_129\_9\_20170425\_00022.jpg

LM Start	0.00	Rating **	M	Issue No.	9
LM End	3.31	Issue Type +	Ma	Location *	LS
Category	Earthen Levee			GPS Latitude/Longitude	
				Start	End
Item	Vegetation			37.202748 °	37.202308 °
				-120.755283 °	-120.695252 °
DWR ID	DWR_NA0010_11_s_2017_9				
Comment Code					
V1 : Control annual grass and weeds on the levee slopes and easements.					
Inspector Comment

Looking at typical view of landward slope.

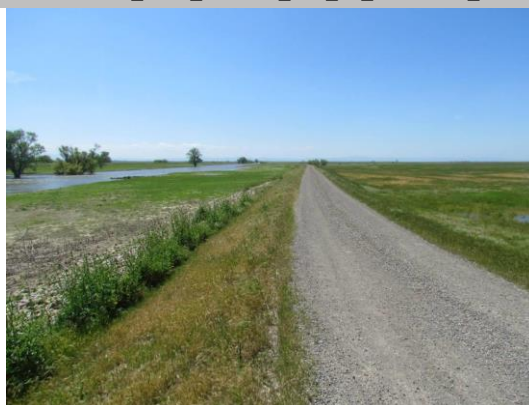
Photo 1 of 1 : SP\_2017\_NA0010\_129\_10\_20170425\_00023.jpg

LM Start	0.00	Rating **	M	Issue No.	10
LM End	3.31	Issue Type +	Ma	Location *	WS
Category	Earthen Levee			GPS Latitude/Longitude	
				Start	End
Item	Vegetation			37.202748 °	37.202308 °
				-120.755283 °	-120.695252 °
DWR ID	DWR_NA0010_11_s_2017_10				
Comment Code					
V1 : Control annual grass and weeds on the levee slopes and easements.					
Inspector Comment

Looking at typical view of waterward slope.

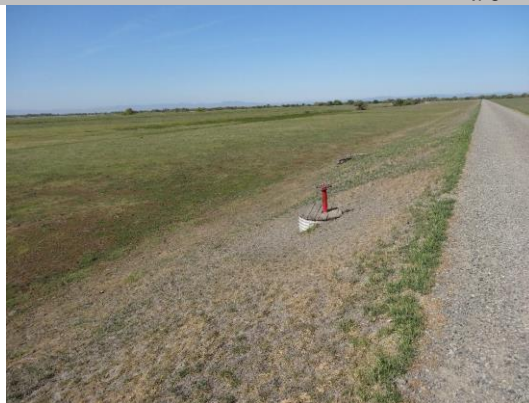
Photo 1 of 3 : UCIP\_SP\_2017\_39517\_66644.jpg

LM Start	0.42	Rating **	M	Issue No.	11
LM End	0.42	Issue Type +	Ma	Location *	WS
Category	Supplemental			GPS Latitude/Longitude	
				Start	End
Item	DWR UCIP LMA Responsibility			37.202754 °	37.202754 °
				-120.747689 °	-120.747689 °
DWR ID					
Comment Code					
Inspector Comment					
FS_ID:39517					
DS_ID:19846					
EP_NO: N/A					
Repair Type: Non-Urgent					
Crossing Status: Found					
UCIP Comments: Need to contact owner. Recommend clearing sediment deposit inside pipe.					
FIELD_STRUCT_DESC: 24-inch C.M. pipe through the levee, 11.0 feet below the crown. Slide gate inside CMP riser located on the waterward end. (USACE-1967). This entry matches the Drainage or Irrigation Structure referenced in O&M manual (HLM 0.42).					
FS Date: 4/18/2014

View of slide gate inside CMP riser located on waterward slope.

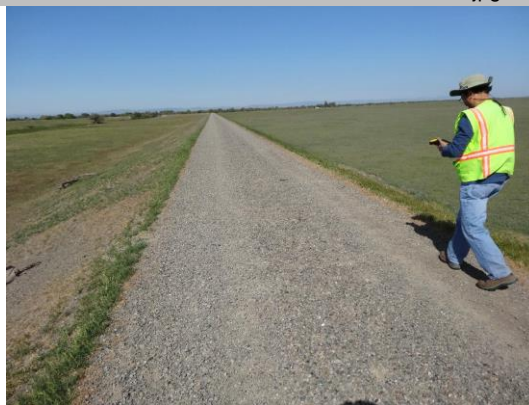
Photo 2 of 3 : UCIP\_SP\_2017\_39517\_66643.jpg

View of levee crown at crossing.

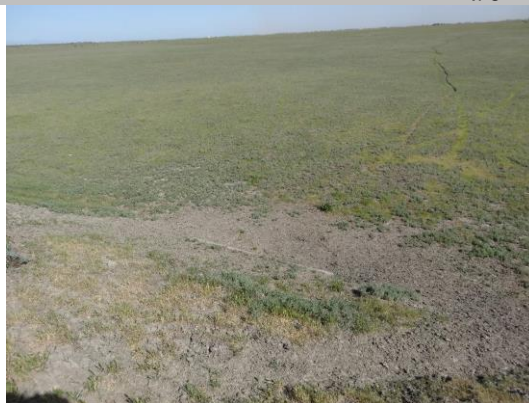
Photo 3 of 3 : UCIP\_SP\_2017\_39517\_66642.jpg

LM Start	0.42	Rating **	M	Issue No.	11 (cont)
LM End	0.42	Issue Type +	Ma	Location *	WS
Category	Supplemental			GPS Latitude/Longitude	
				Start	End
Item	DWR UCIP LMA Responsibility			37.202754 °	37.202754 °
				-120.747689 °	-120.747689 °
DWR ID					
Comment Code					
Inspector Comment					
FS_ID:39517					
DS_ID:19846					
EP_NO: N/A					
Repair Type: Non-Urgent					
Crossing Status: Found					
UCIP Comments: Need to contact owner. Recommend clearing sediment deposit inside pipe.					
FIELD_STRUCT_DESC: 24-inch C.M. pipe through the levee, 11.0 feet below the crown. Slide gate inside CMP riser located on the waterward end. (USACE-1967). This entry matches the Drainage or Irrigation Structure referenced in O&M manual (HLM 0.42).					
FS Date: 4/18/2014

View of landward side.

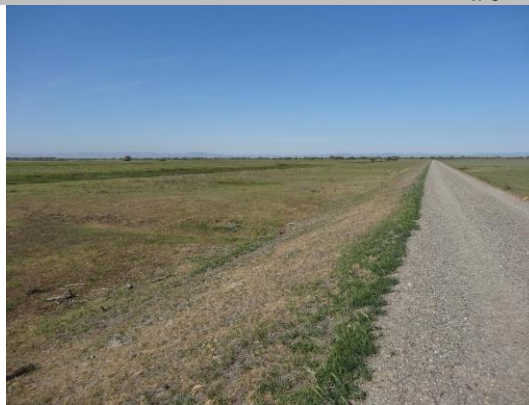
Photo 1 of 3 : UCIP\_SP\_2017\_39518\_61997.jpg

LM Start	0.65	Rating **	M	Issue No.	12
LM End	0.65	Issue Type +	Ma	Location *	WS
Category	Supplemental			GPS Latitude/Longitude	
				Start	End
Item	DWR UCIP LMA Responsibility			37.202751 °	37.202751 °
				-120.743474 °	-120.743474 °
DWR ID					
Comment Code					
Inspector Comment					
FS_ID:39518 DS_ID:19847 EP_NO: N/A Repair Type: Non-Urgent Crossing Status: Found UCIP Comments: Need to contact owner. Recommend clearing sediment deposit inside pipe. FIELD_STRUCT_DESC: 24-inch C.M. pipe through the levee, 10.0 feet below the crown. Flap gate on the waterward end. (USACE-1967). This entry matches the Drainage or Irrigation Structure referenced in O&M manual (HLM 0.65). FS Date: 4/18/2014

View of waterward side.

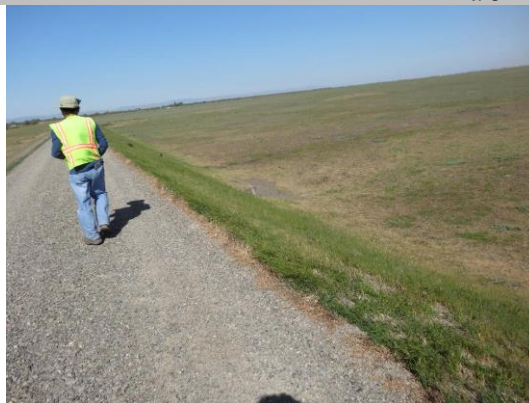
Photo 2 of 3 : UCIP\_SP\_2017\_39518\_61996.jpg

View of landward side.

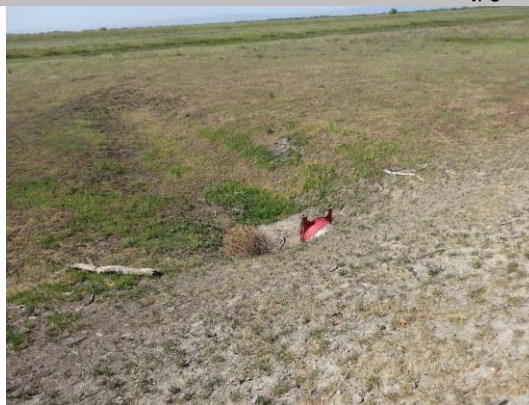
Photo 3 of 3 : UCIP\_SP\_2017\_39518\_61999.jpg

Flap gate and concrete apron located on waterward side.

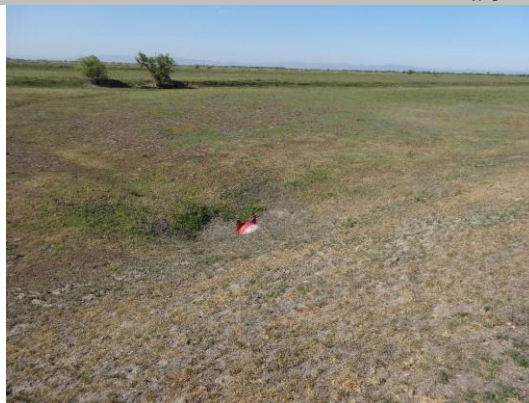
Photo 1 of 3 : UCIP\_SP\_2017\_39519\_62003.jpg

LM Start	0.84	Rating **	M	Issue No.	13
LM End	0.84	Issue Type +	Ma	Location *	WS
Category	Supplemental			GPS Latitude/Longitude	
				Start	End
Item	DWR UCIP LMA Responsibility			37.202745 °	37.202745 °
				-120.739935 °	-120.739935 °
DWR ID					
Comment Code					
Inspector Comment					
FS_ID:39519					
DS_ID:19848					
EP_NO: N/A					
Repair Type: Non-Urgent					
Crossing Status: Found					
UCIP Comments: Need to contact owner. Recommend clearing sediment deposit inside pipe.					
FIELD_STRUCT_DESC: 24-inch C.M. pipe through the levee, 10.3 feet below the crown. Flap gate on the waterward end. (USACE-1967). This entry matches the Drainage or Irrigation Structure referenced in O&M manual (HLM 0.84).					
FS Date: 4/18/2014

Overview of waterward side.

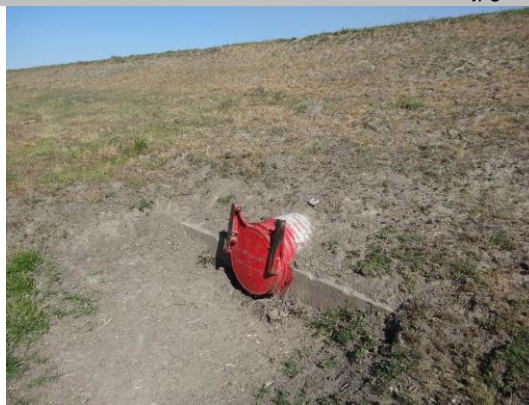
Photo 2 of 3 : UCIP\_SP\_2017\_39519\_62002.jpg

Concrete headwall and flap gate visible on waterward side.

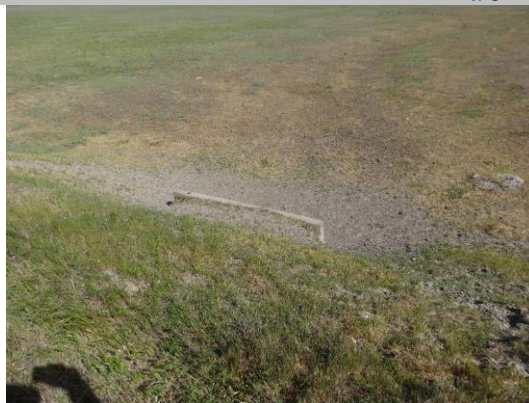
Photo 3 of 3 : UCIP\_SP\_2017\_39519\_62001.jpg

View of landward side.

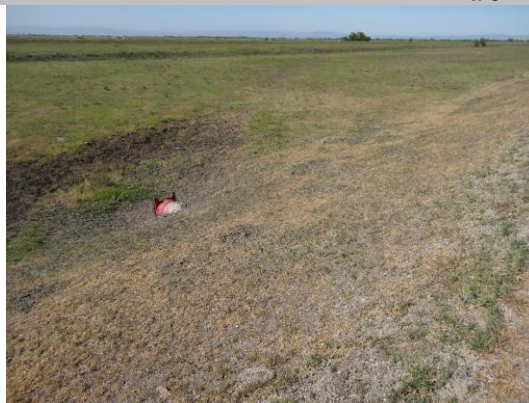
Photo 1 of 3 : UCIP\_SP\_2017\_39520\_62008.jpg

LM Start	1.13	Rating **	M	Issue No.	14
LM End	1.13	Issue Type +	Ma	Location *	WS
Category	Supplemental			GPS Latitude/Longitude	
				Start	End
Item	DWR UCIP LMA Responsibility			37.202748 °	37.202748 °
				-120.734796 °	-120.734796 °
DWR ID					
Comment Code					
Inspector Comment					
FS_ID:39520 DS_ID:19849 EP_NO: N/A Repair Type: Non-Urgent Crossing Status: Found UCIP Comments: Need to contact owner. Recommend clearing sediment deposit inside pipe. FIELD_STRUCT_DESC: 24-inch C.M. pipe through the levee, 9.0 feet below the crown. Flap gate on the waterward end. (USACE-1967). This entry matches the Drainage or Irrigation Structure referenced in O&M manual (HLM 1.13). FS Date: 4/18/2014

View of waterward side--flap gate visible at levee toe.

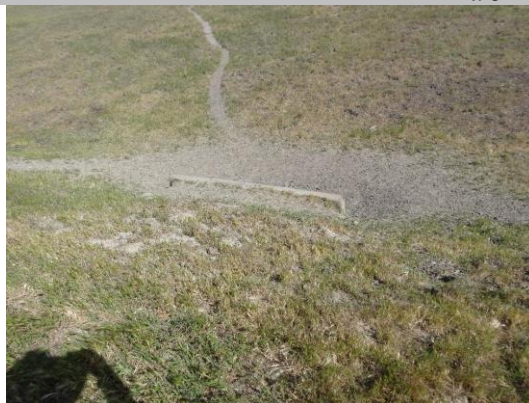
Photo 2 of 3 : UCIP\_SP\_2017\_39520\_62007.jpg

View of landward side.

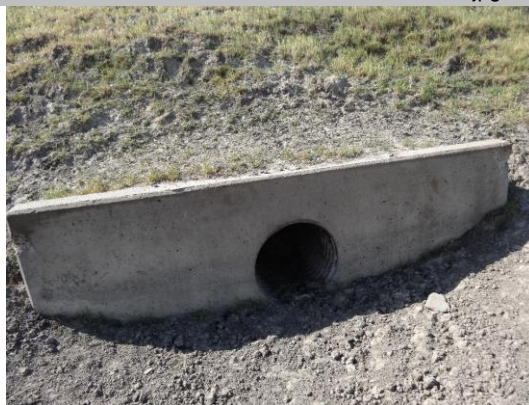
Photo 3 of 3 : UCIP\_SP\_2017\_39520\_62006.jpg

Concrete headwall located on landward side.

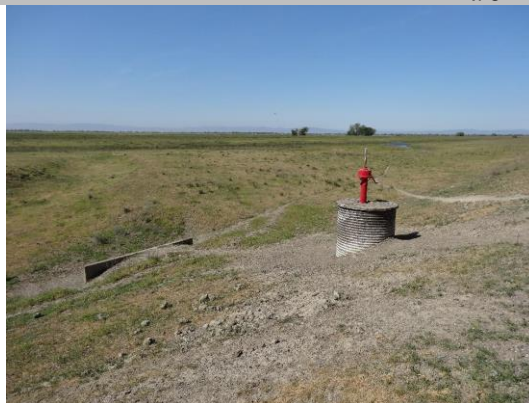
Photo 1 of 3 : UCIP\_SP\_2017\_39521\_62018.jpg

LM Start	1.49	Rating **	M	Issue No.	15
LM End	1.49	Issue Type +	Ma	Location *	WS
Category	Supplemental			GPS Latitude/Longitude	
				Start	End
Item	DWR UCIP LMA Responsibility			37.202753 °	37.202753 °
				-120.728133 °	-120.728133 °
DWR ID					
Comment Code					
Inspector Comment					
FS_ID:39521					
DS_ID:19850					
EP_NO: N/A					
Repair Type: Non-Urgent					
Crossing Status: Found					
UCIP Comments: Need to contact owner. Recommend clearing sediment deposit inside pipe.					
FIELD_STRUCT_DESC: 48-inch C.M. pipe through the levee, 16.3 feet below the crown. Slide gate in riser pipe on the waterward slope. (USACE-1967). This entry matches the Drainage or Irrigation Structure referenced in O&M manual (HLM 1.50).					
FS Date: 4/18/2014

View of waterward side.

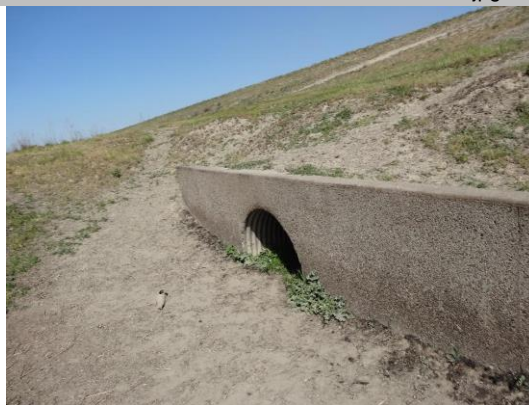
Photo 2 of 3 : UCIP\_SP\_2017\_39521\_62017.jpg

View of concrete headwall located on waterward side.

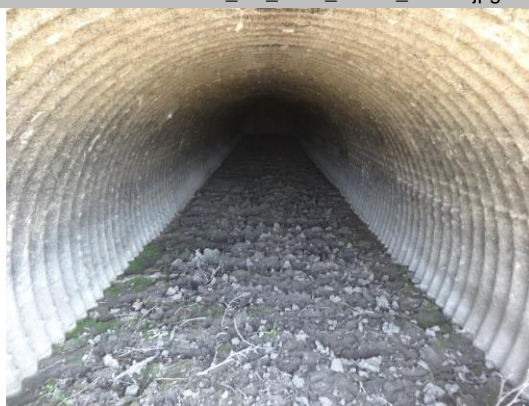
Photo 3 of 3 : UCIP\_SP\_2017\_39521\_62016.jpg

Inside view of pipe from waterward side--sediment build up.

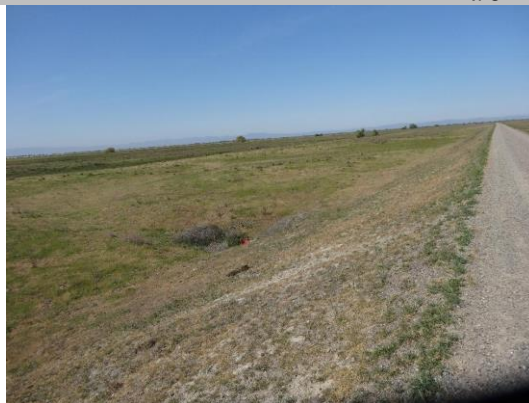
Photo 1 of 3 : UCIP\_SP\_2017\_39522\_62024.jpg

LM Start	1.98	Rating **	M	Issue No.	16
LM End	1.98	Issue Type +	Ma	Location *	LS
Category	Supplemental			GPS Latitude/Longitude	
				Start	End
Item	DWR UCIP LMA Responsibility			37.202740 °	37.202740 °
				-120.719247 °	-120.719247 °
DWR ID					
Comment Code					
Inspector Comment					
FS_ID:39522 DS_ID:19851 EP_NO: N/A Repair Type: Non-Urgent Crossing Status: Found UCIP Comments: Need to contact owner. Recommend clearing sediment deposit inside pipe. FIELD_STRUCT_DESC: 24-inch C.M. pipe through the levee, 12.8 feet below the crown. Flap gate on the waterward end. (USACE-1967). This entry matches the Drainage or Irrigation Structure referenced in O&M manual (HLM 1.99). FS Date: 4/18/2014

View of waterward side.

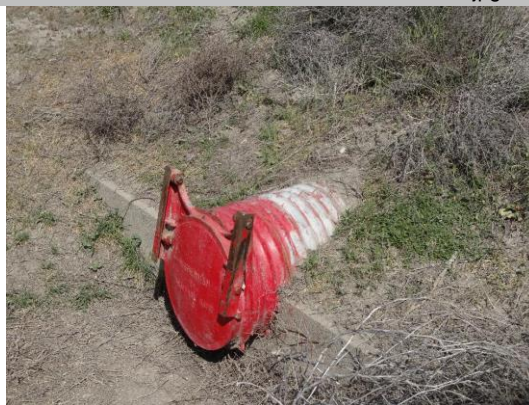
Photo 2 of 3 : UCIP\_SP\_2017\_39522\_62025.jpg

Flap gate located on waterward side.

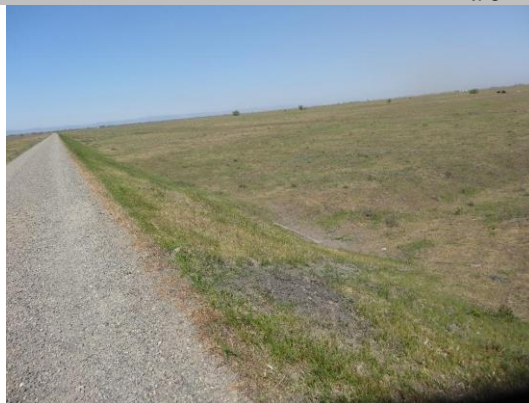
Photo 3 of 3 : UCIP\_SP\_2017\_39522\_62023.jpg

View of landward side.

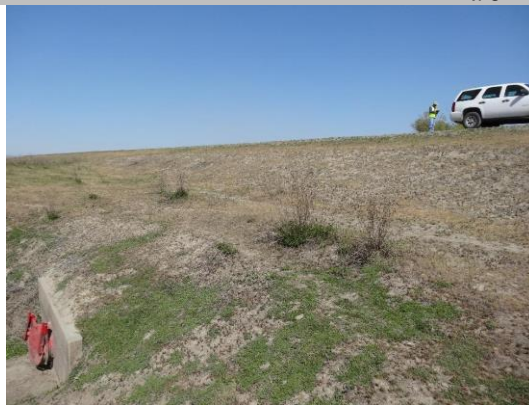
Photo 1 of 3 : UCIP\_SP\_2017\_39523\_62028.jpg

LM Start	3.04	Rating **	M	Issue No.	17
LM End	3.04	Issue Type +	Ma	Location *	LS
Category	Supplemental			GPS Latitude/Longitude	
				Start	End
Item	DWR UCIP LMA Responsibility			37.202494 °	37.202494 °
				-120.700153 °	-120.700153 °
DWR ID					
Comment Code					
Inspector Comment					
FS_ID:39523 DS_ID:19852 EP_NO: N/A Repair Type: Non-Urgent Crossing Status: Found UCIP Comments: Need to contact owner. Recommend clearing sediment deposit inside pipe. FIELD_STRUCT_DESC: 24-inch C.M. pipe through the levee, 15.0 feet below the crown. Flap gate on the waterward end. (USACE-1967). This entry matches the Drainage or Irrigation Structure referenced in O&M manual (HLM 3.04). FS Date: 4/18/2014

Overview of waterward side--flap gate, concrete headwall and apron visible on levee toe.

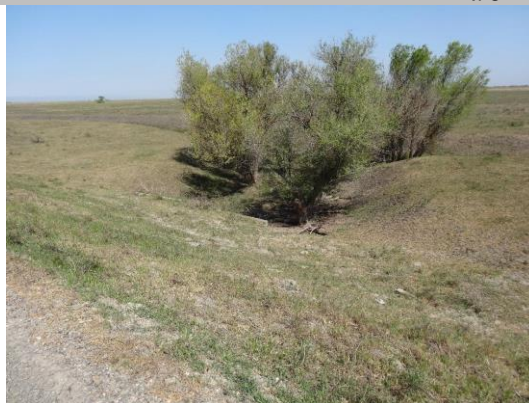
Photo 2 of 3 : UCIP\_SP\_2017\_39523\_62027.jpg

View of landward side.

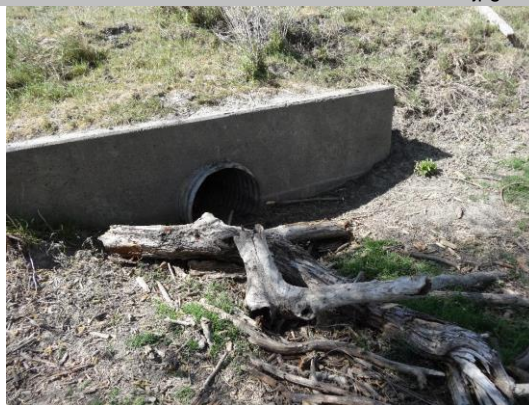
Photo 3 of 3 : UCIP\_SP\_2017\_39523\_62030.jpg

Concrete headwall located on landward side--debris in front of headwall.

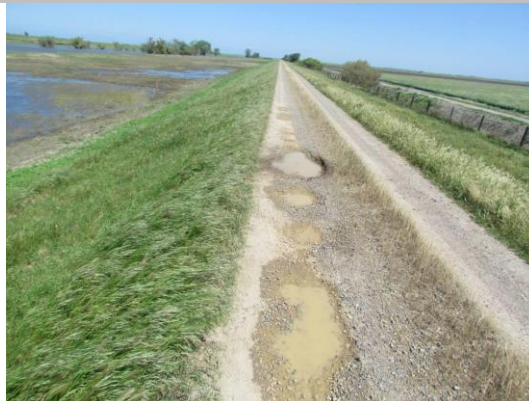
Photo 1 of 1 : SP\_2017\_NA0010\_130\_12\_20170425\_00022.jpg

LM Start	0.00	Rating **	M	Issue No.	12
LM End	2.75	Issue Type +	Ma	Location *	CR
Category	Earthen Levee			GPS Latitude/Longitude	
				Start	End
Item	Crown Surface / Depressions / Rutting			37.200958 °	37.200918 °
				-120.755207 °	-120.705467 °
DWR ID	DWR_NA0010_12_s_2017_12				
Comment Code					
C2 : Repair depressions or ruts in the crown or slope.					
Inspector Comment					
Several pot holes along levee crown.

Looking downstream at typical view of pot holes and rutting on levee crown.

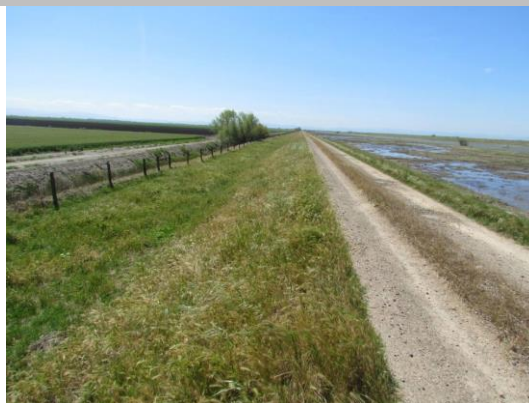
Photo 1 of 1 : SP\_2017\_NA0010\_130\_10\_20170425\_00024.jpg

LM Start	0.00	Rating **	M	Issue No.	10
LM End	3.33	Issue Type +	Ma	Location *	LS
Category	Earthen Levee			GPS Latitude/Longitude	
				Start	End
Item	Vegetation			37.200958 °	37.201045 °
				-120.755207 °	-120.694823 °
DWR ID	DWR_NA0010_12_s_2017_10				
Comment Code					
V1 : Control annual grass and weeds on the levee slopes and easements.					
Inspector Comment

Looking at typical view of landward slope.

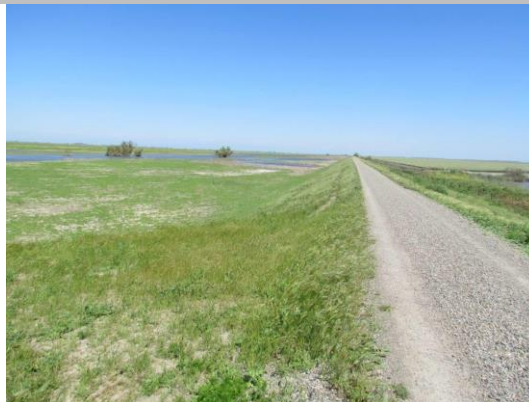
Photo 1 of 1 : SP\_2017\_NA0010\_130\_11\_20170425\_00023.jpg

LM Start	0.00	Rating **	M	Issue No.	11
LM End	3.33	Issue Type +	Ma	Location *	WS
Category	Earthen Levee			GPS Latitude/Longitude	
				Start	End
Item	Vegetation			37.200958 °	37.201045 °
				-120.755207 °	-120.694823 °
DWR ID	DWR_NA0010_12_s_2017_11				
Comment Code					
V1 : Control annual grass and weeds on the levee slopes and easements.					
Inspector Comment

Looking at typical view of waterward slope.

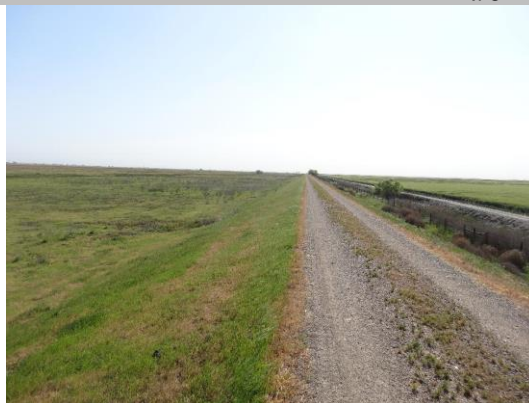
Photo 1 of 3 : UCIP\_SP\_2017\_36704\_66647.jpg

LM Start	0.40	Rating **	M	Issue No.	13
LM End	0.40	Issue Type +	Ma	Location *	WS
Category	Supplemental			GPS Latitude/Longitude	
				Start	End
Item	DWR UCIP LMA Responsibility			37.200934 °	37.200934 °
				-120.747996 °	-120.747996 °
DWR ID					
Comment Code					
Inspector Comment					
FS_ID:36704 DS_ID:19855 EP_NO: N/A Repair Type: Non-Urgent Crossing Status: Found UCIP Comments: Need to contact owner. Dense vegetation limits the inspector's visibility to identify signs of pipe failure (leaks) along the waterward slope. Recommend removing vegetation along pipe alignment to conduct proper inspection of structure. FIELD_STRUCT_DESC: 24-inch CM pipe through levee, 10.5 feet below crown. Flap gate on the waterward end. (USACE-1967). This entry matches the Drainage or Irrigation Structure referenced in O&M manual (HLM 0.39). FS Date: 4/18/2014

View of waterward side.

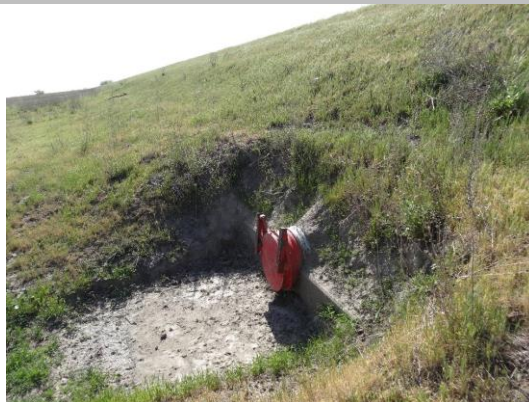
Photo 2 of 3 : UCIP\_SP\_2017\_36704\_66649.jpg

Concrete headwall and flap gate visible on waterward side.

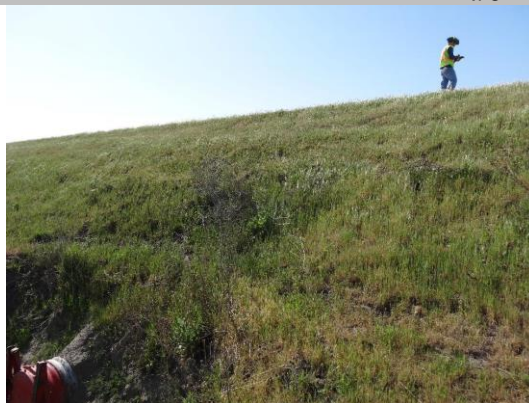
Photo 3 of 3 : UCIP\_SP\_2017\_36704\_66648.jpg

LM Start	0.40	Rating **	M	Issue No.	13 (cont)	
LM End	0.40	Issue Type +	Ma	Location *	WS	
Category	Supplemental			GPS Latitude/Longitude		
				Start		End
Item	DWR UCIP LMA Responsibility			37.200934 °	37.200934 °	
				-120.747996 °	-120.747996 °	
DWR ID						
Comment Code						
Inspector Comment						
FS_ID:36704 DS_ID:19855 EP_NO: N/A Repair Type: Non-Urgent Crossing Status: Found UCIP Comments: Need to contact owner. Dense vegetation limits the inspector's visibility to identify signs of pipe failure (leaks) along the waterward slope. Recommend removing vegetation along pipe alignment to conduct proper inspection of structure. FIELD_STRUCT_DESC: 24-inch CM pipe through levee, 10.5 feet below crown. Flap gate on the waterward end. (USACE-1967). This entry matches the Drainage or Irrigation Structure referenced in O&M manual (HLM 0.39). FS Date: 4/18/2014

View of waterward side--medium grass throughout slope.

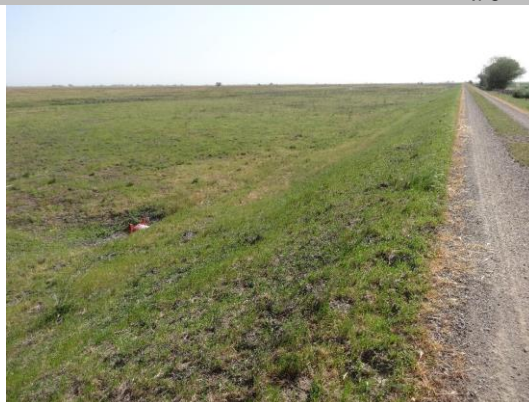
Photo 1 of 3 : UCIP\_SP\_2017\_39889\_62048.jpg

LM Start	1.06	Rating **	M	Issue No.	14
LM End	1.06	Issue Type +	Ma	Location *	WS
Category	Supplemental			GPS Latitude/Longitude	
				Start	End
Item	DWR UCIP LMA Responsibility			37.200922 °	37.200922 °
				-120.736012 °	-120.736012 °
DWR ID					
Comment Code					
Inspector Comment					
FS_ID:39889					
DS_ID:19856					
EP_NO: N/A					
Repair Type: Non-Urgent					
Crossing Status: Found					
UCIP Comments: Need to contact owner. Recommend clearing sediment deposit inside pipe.					
FIELD_STRUCT_DESC: 24-inch CM pipe through levee, 10.5 feet below crown. Flap gate on the waterward end. (USACE-1967). This entry matches the Drainage or Irrigation Structure referenced in O&M manual (HLM 1.06).					
FS Date: 4/18/2014

View of waterward side.

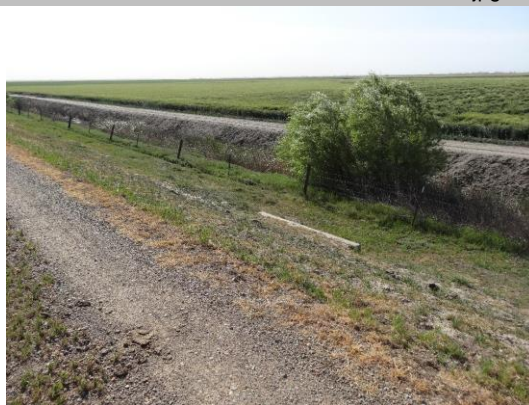
Photo 3 of 3 : UCIP\_SP\_2017\_39889\_62047.jpg

View of landward side.

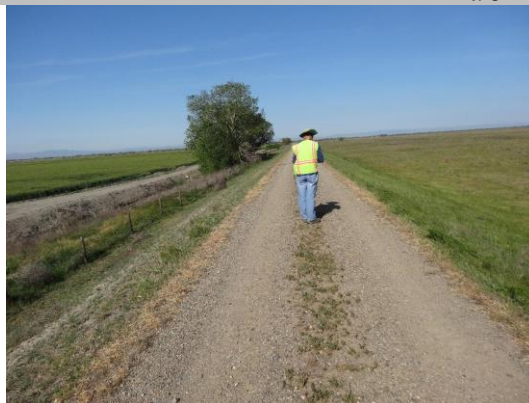
Photo 1 of 3 : UCIP\_SP\_2017\_36705\_66654.jpg

Comment Code					
Inspector Comment					
FS_ID:36705 DS_ID:19857 EP_NO: N/A Repair Type: Non-Urgent Crossing Status: Found UCIP Comments: Landward side not accessible due to dense vegetation and fence. Concrete headwall and flap gate under water therefore not able to evaluate condition. Will need to coordinate with owner to evaluate condition of crossing on waterward side and obtain access to evaluate landward side. FIELD_STRUCT_DESC: 24-inch CM pipe through levee, 17.4 feet below crown. Flap gate on the waterward end. (USACE-1967). This entry matches the Drainage or Irrigation Structure referenced in O&M manual (HLM 1.27). FS Date: 4/18/2014

Overview of levee crown at crossing.

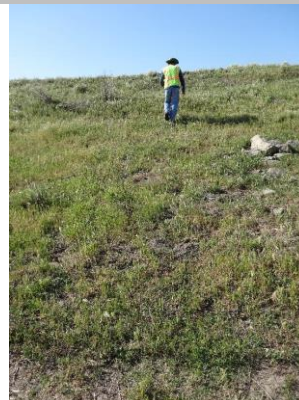
Photo 2 of 3 : UCIP\_SP\_2017\_36705\_66652.jpg

View of waterward slope.

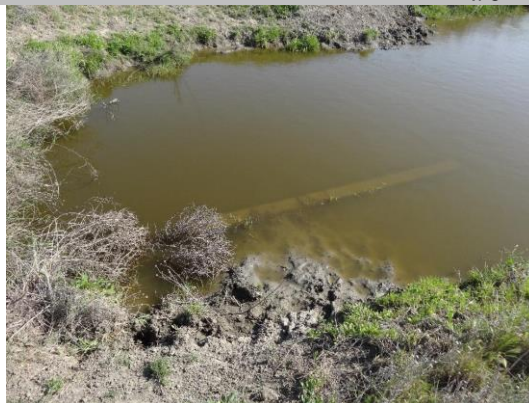
Photo 3 of 3 : UCIP\_SP\_2017\_36705\_66653.jpg

Comment Code						
Inspector Comment						
FS_ID:36705						
DS_ID:19857						
EP_NO: N/A						
Repair Type: Non-Urgent						
Crossing Status: Found						
UCIP Comments: Landward side not accessible due to dense vegetation and fence. Concrete headwall and flap gate under water therefore not able to evaluate condition. Will need to coordinate with owner to evaluate condition of crossing on waterward side and obtain access to evaluate landward side.						
FIELD_STRUCT_DESC: 24-inch CM pipe through levee, 17.4 feet below crown. Flap gate on the waterward end. (USACE-1967). This entry matches the Drainage or Irrigation Structure referenced in O&M manual (HLM 1.27).						
FS Date: 4/18/2014

View of concrete wall underwater.

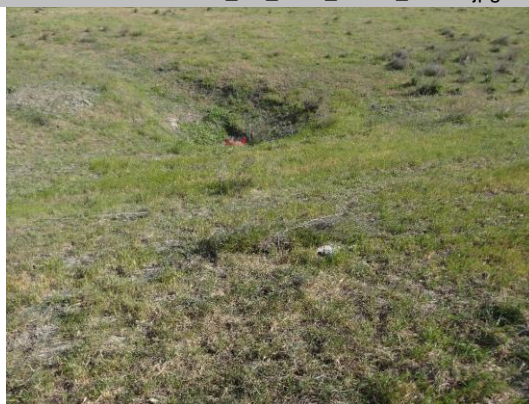
Photo 1 of 3 : UCIP\_SP\_2017\_34126\_62060.jpg

LM Start	1.53	Rating **	M	Issue No.	16
LM End	1.53	Issue Type +	Ma	Location *	WS
Category	Supplemental			GPS Latitude/Longitude	
				Start	End
Item	DWR UCIP LMA Responsibility			37.200913 °	37.200913 °
				-120.727496 °	-120.727496 °
DWR ID					
Comment Code					
Inspector Comment					
FS_ID:34126 DS_ID:19858 EP_NO: N/A Repair Type: Non-Urgent Crossing Status: Found UCIP Comments: Limited access on landward side due to fence and dense vegetation. Recommend obtaining access to landward side and clear vegetation on landward side. FIELD_STRUCT_DESC: 24-inch CM pipe through levee, 10.7 feet below crown. Flap gate on the waterward end. (USACE-1967). This entry matches the Drainage or Irrigation Structure referenced in O&M manual (HLM 1.53). FS Date: 4/18/2014

View of waterward side.

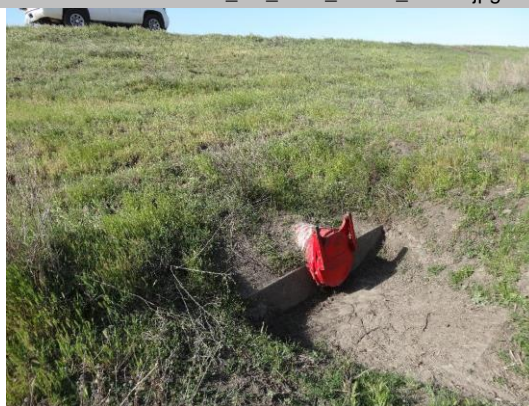
Photo 2 of 3 : UCIP\_SP\_2017\_34126\_62061.jpg

Concrete headwall and flap gate visible on waterward side.

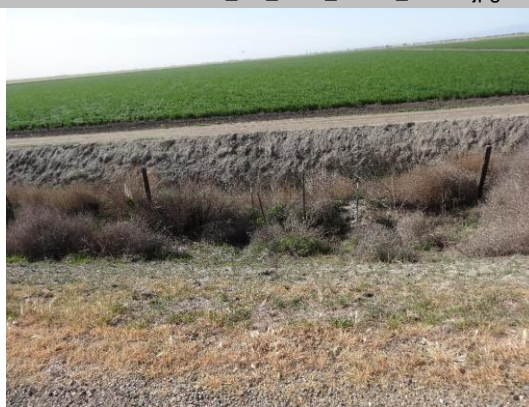
Photo 3 of 3 : UCIP\_SP\_2017\_34126\_62059.jpg

View of landward side--limited access due to fence.

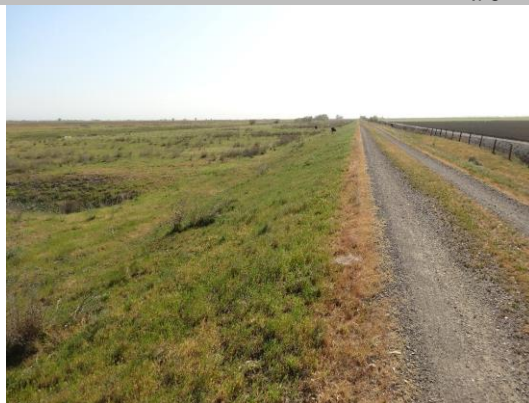
Photo 1 of 3 : UCIP\_SP\_2017\_39506\_62064.jpg

LM Start	2.16	Rating **	M	Issue No.	17
LM End	2.16	Issue Type +	Ma	Location *	WS
Category	Supplemental			GPS Latitude/Longitude	
				Start	End
Item	DWR UCIP LMA Responsibility			37.200908 °	37.200908 °
				-120.716118 °	-120.716118 °
DWR ID					
Comment Code					
Inspector Comment					
FS_ID:39506					
DS_ID:19859					
EP_NO: N/A					
Repair Type: Non-Urgent					
Crossing Status: Found					
UCIP Comments: Need to contact owner. Recommend clearing vegetation from landward side--headwall blocked.					
FIELD_STRUCT_DESC: 24-inch CM pipe through levee, 14.4 feet below crown. Flap gate on the waterward end. (USACE-1967). This entry matches the Drainage or Irrigation Structure referenced in O&M manual (HLM 2.16).					
FS Date: 4/18/2014

View of waterward side.

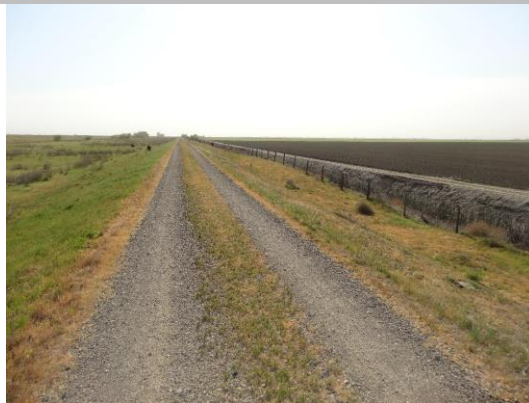
Photo 2 of 3 : UCIP\_SP\_2017\_39506\_62063.jpg

Overview of levee crown at crossing.

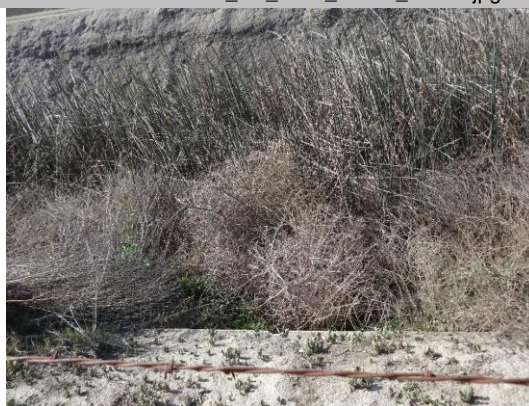
Photo 3 of 3 : UCIP\_SP\_2017\_39506\_62062.jpg

LM Start	2.16	Rating **	M	Issue No.	17 (cont)	
LM End	2.16	Issue Type +	Ma	Location *	WS	
Category	Supplemental			GPS Latitude/Longitude		
				Start	End	
Item	DWR UCIP LMA Responsibility			37.200908 °	37.200908 °	
				-120.716118 °	-120.716118 °	
DWR ID						
Comment Code						
Inspector Comment						
FS_ID:39506						
DS_ID:19859						
EP_NO: N/A						
Repair Type: Non-Urgent						
Crossing Status: Found						
UCIP Comments: Need to contact owner. Recommend clearing vegetation from landward side--headwall blocked.						
FIELD_STRUCT_DESC: 24-inch CM pipe through levee, 14.4 feet below crown. Flap gate on the waterward end. (USACE-1967). This entry matches the Drainage or Irrigation Structure referenced in O&M manual (HLM 2.16).						
FS Date: 4/18/2014

Dense vegetation on landward side--limited access due to fence along landward side.

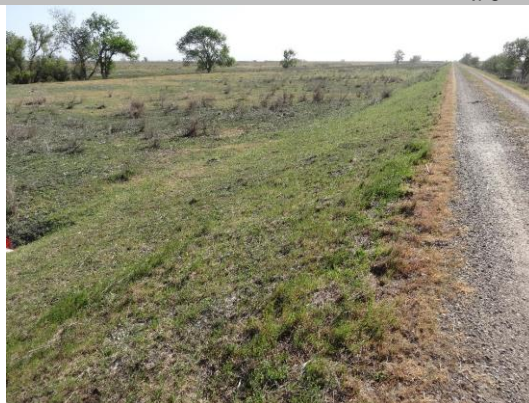
Photo 1 of 3 : UCIP\_SP\_2017\_39890\_62069.jpg

View of waterward side.

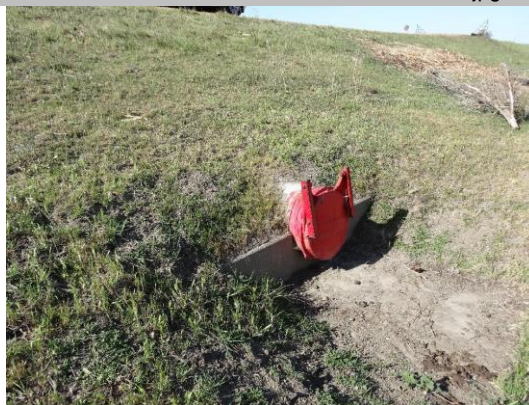
Photo 2 of 3 : UCIP\_SP\_2017\_39890\_62070.jpg

Concrete headwall and flat gate located on waterward side.

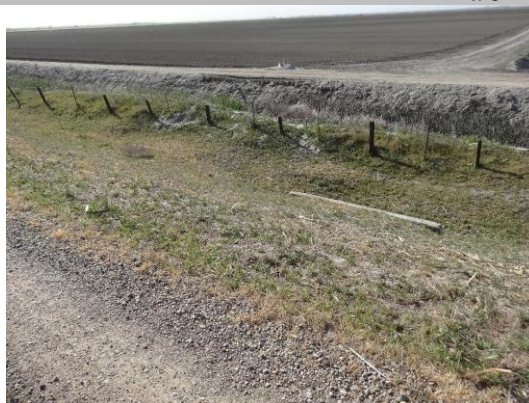
Photo 3 of 3 : UCIP\_SP\_2017\_39890\_62068.jpg

LM Start	2.70	Rating **	M	Issue No.	18 (cont)	
LM End	2.70	Issue Type +	Ma	Location *	LS	
Category	Supplemental			GPS Latitude/Longitude		
				Start		End
Item	DWR UCIP LMA Responsibility			37.200906 °		37.200906 °
				-120.706316 °		-120.706316 °
DWR ID						
Comment Code						
Inspector Comment						
FS_ID:39890						
DS_ID:19860						
EP_NO: N/A						
Repair Type: Non-Urgent						
Crossing Status: Found						
UCIP Comments: Need to contact owner. Recommend clearing sediment deposit inside pipe.						
FIELD_STRUCT_DESC: 24-inch CM pipe through levee, 10.7 feet below crown. Flap gate on the waterward end. (USACE-1967). This entry matches the Drainage or Irrigation Structure referenced in O&M manual (HLM 2.70).						
FS Date: 4/18/2014

View of landward side.
