**Flood Control Project Maintenance  
Levee Inspections**  
**LMA District Cover Sheet**  
**Spring 2017 Levee Inspection Results**

**Lower San Joaquin Levee District**

Waterway			Bank	Unit Miles
Unit No. 01 San Joaquin River			Right	22.52
	Spring (March - May)	Summer (June - August)	(September - November) Fall	Winter (December - February)
Unit Maintenance Rating (Fall Only)				
Date of Inspection	4/17/2017 - 4/20/2017			
DWR Inspector	Richard Willoughby			
Accompanied By

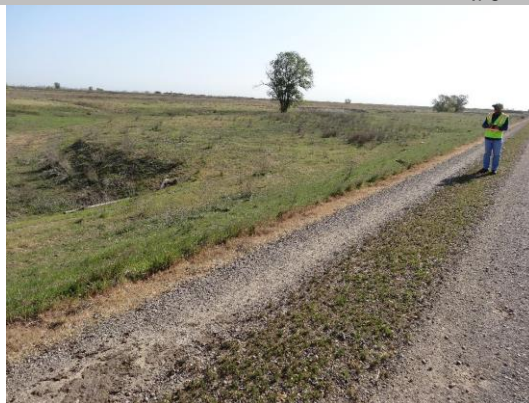
Photo 1 of 3 : UCIP\_SP\_2017\_46786\_62073.jpg

Comment Code					
Inspector Comment					
FS_ID:46786 DS_ID:19861 EP_NO: N/A Repair Type: Non-Urgent Crossing Status: Found UCIP Comments: 11-09-2015 DWR Inspection section confirmed issue has been addressed. Need to coordinate with LMA to determine additional details for extent of repair. 10-18-2014 Soil missing behind concrete headwall on waterward side. Unable to determine if missing soil is due to sink holes, rodent activity, or due to erosion. Headwall appears to be leaning slightly forward. Reason why this crossing was labelled urgent was due to the uncertainty of damage to concrete headwall and reason for soil missing behind concrete. Need to coordinate with LMA to determine more information about repair at this location. FIELD_STRUCT_DESC: 24-inch CM pipe through levee, 2 feet below levee crown. Flap gate on the waterward end. (USACE-1967). This entry matches the Drainage or Irrigation Structure referenced in O&M manual (HLM 3.00). FS Date: 11/10/2015 9:29:00 AM

View of waterward side.

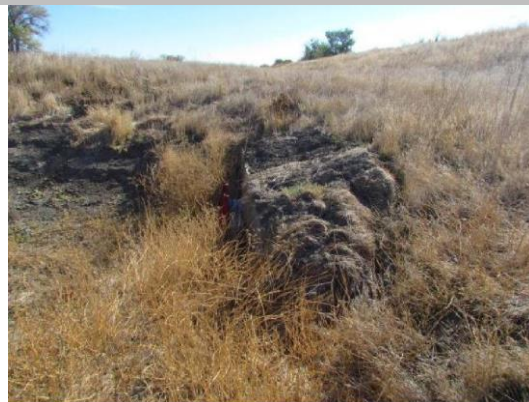
Photo 2 of 3 : UCIP\_SP\_2017\_46786\_74729.jpg

Repair to headwall located on waterward side has been addressed.

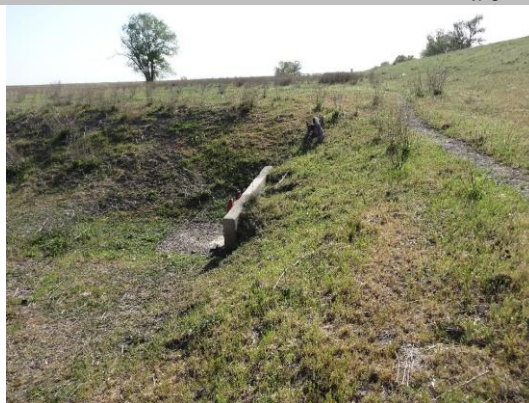
Photo 3 of 3 : UCIP\_SP\_2017\_46786\_62072.jpg

Comment Code						
Inspector Comment						
FS_ID:46786 DS_ID:19861 EP_NO: N/A Repair Type: Non-Urgent Crossing Status: Found UCIP Comments: 11-09-2015 DWR Inspection section confirmed issue has been addressed. Need to coordinate with LMA to determine additional details for extent of repair. 10-18-2014 Soil missing behind concrete headwall on waterward side. Unable to determine if missing soil is due to sink holes, rodent activity, or due to erosion. Headwall appears to be leaning slightly forward. Reason why this crossing was labelled urgent was due to the uncertainty of damage to concrete headwall and reason for soil missing behind concrete. Need to coordinate with LMA to determine more information about repair at this location. FIELD_STRUCT_DESC: 24-inch CM pipe through levee, 2 feet below levee crown. Flap gate on the waterward end. (USACE-1967). This entry matches the Drainage or Irrigation Structure referenced in O&M manual (HLM 3.00). FS Date: 11/10/2015 9:29:00 AM

Side view of concrete headwall which appears to be slightly slanted forward--missing soil behind headwall.

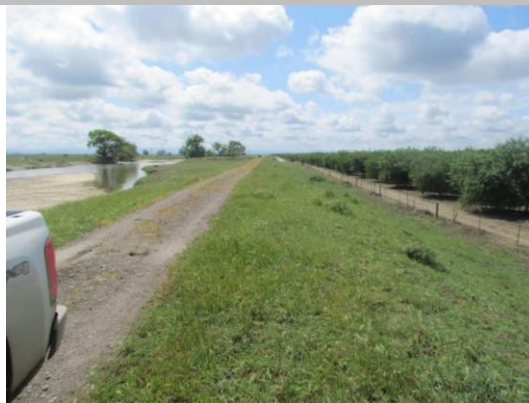
Photo 1 of 1 : SP\_2017\_NA0010\_131\_7\_20170425\_00017.jpg

LM Start	0.02	Rating **	M	Issue No.	7
LM End	1.26	Issue Type +	Ma	Location *	LS
Category	Earthen Levee			GPS Latitude/Longitude	
				Start	End
Item	Vegetation			37.034032 °	37.046342 °
				-120.441967 °	-120.428060 °
DWR ID	DWR_NA0010_13_s_2017_7				
Comment Code					
V1 : Control annual grass and weeds on the levee slopes and easements.					
Inspector Comment

Looking at typical view of landward slope.

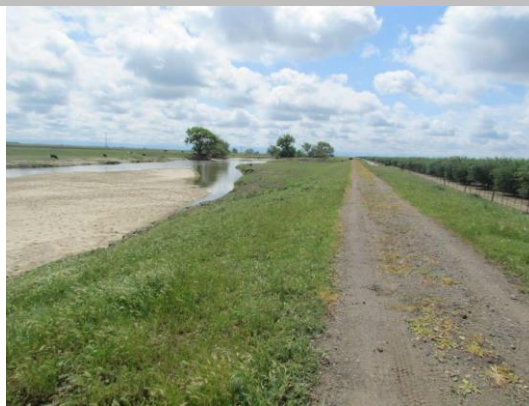
Photo 1 of 1 : SP\_2017\_NA0010\_131\_8\_20170425\_00016.jpg

LM Start	0.02	Rating **	M	Issue No.	8
LM End	1.26	Issue Type +	Ma	Location *	WS
Category	Earthen Levee			GPS Latitude/Longitude	
				Start	End
Item	Vegetation			37.034032 °	37.046342 °
				-120.441967 °	-120.428060 °
DWR ID	DWR_NA0010_13_s_2017_8				
Comment Code					
V1 : Control annual grass and weeds on the levee slopes and easements.					
Inspector Comment

Looking at typical view of waterward slope.

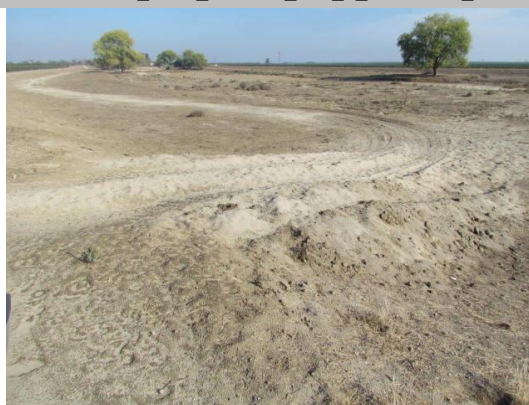
Photo 1 of 3 : SP\_2017\_NA0010\_131\_5\_20170417\_00001.jpg

LM Start	0.91	Rating **	M	Issue No.	5
LM End	0.91	Issue Type +	En	Location *	WS
Category	Earthen Levee			GPS Latitude/Longitude	
				Start	End
Item	Encroachments			37.044855 °	37.044855 °
				-120.434106 °	-120.434106 °
DWR ID	DWR_NA0010_13_s_2014_5				
Comment Code					
RA : Ramp					
Inspector Comment					
Unauthorized ramp on waterward slope.

Looking at unauthorized ramp on waterward slope. (Fall 2014)

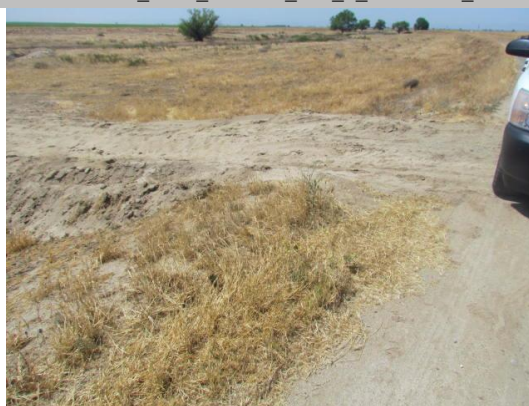
Photo 2 of 3 : SP\_2017\_NA0010\_131\_5\_20170417\_00002.jpg

Looking west at unauthorized ramp on waterward slope.

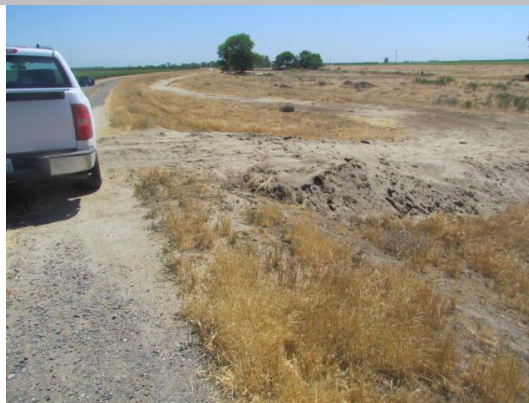
Photo 3 of 3 : SP\_2017\_NA0010\_131\_5\_20170417\_00003.jpg

LM Start	0.91	Rating **	M	Issue No.	5 (cont)	
LM End	0.91	Issue Type +	En	Location *	WS	
Category	Earthen Levee			GPS Latitude/Longitude		
				Start		End
Item	Encroachments			37.044855 °		37.044855 °
				-120.434106 °		-120.434106 °
DWR ID	DWR_NA0010_13_s_2014_5					
Comment Code						
RA : Ramp						
Inspector Comment						
Unauthorized ramp on waterward slope.

Looking east at unauthorized ramp on waterward slope.

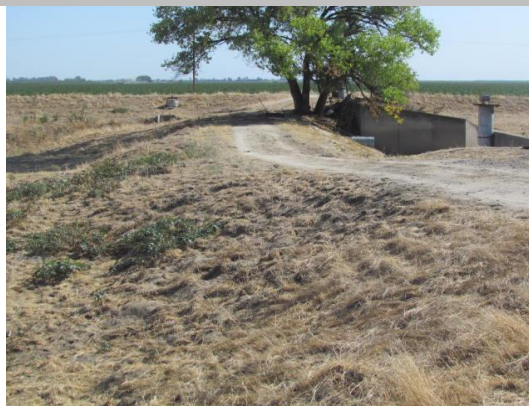
Photo 1 of 6 : SP\_2017\_NA0010\_131\_6\_20170417\_00004.jpg

LM Start	1.14	Rating **	A/W	Issue No.	6
LM End	1.14	Issue Type +	En	Location *	WS
Category	Earthen Levee			GPS Latitude/Longitude	
				Start	End
Item	Encroachments			37.045541 °	37.045541 °
				-120.430014 °	-120.430014 °
DWR ID	DWR_NA0010_13_f_2015_6				
Comment Code					
WL : Wall					
Inspector Comment					
Sand dam has blow out due to water flow.

Looking overview of sand dam.

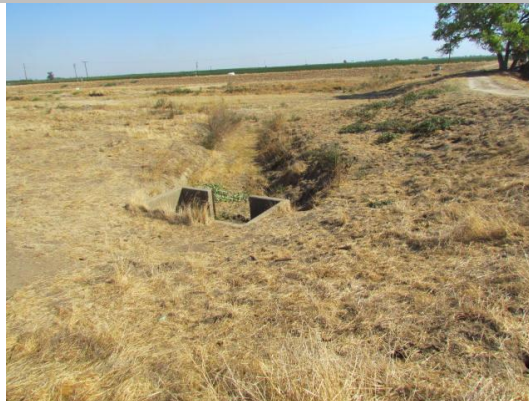
Photo 2 of 6 : SP\_2017\_NA0010\_131\_6\_20170417\_00005.jpg

LM Start	<b>1.14</b>	Rating **	A/W	Issue No.	<b>6 (cont)</b>
LM End	<b>1.14</b>	Issue Type +	En	Location *	WS

Looking west at upstream side of sand dam on the southside of the Drop structure.

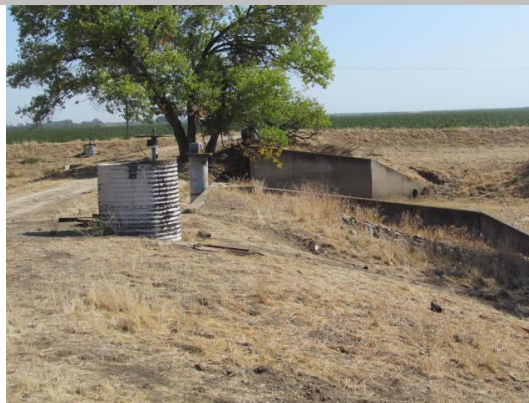
Photo 3 of 6 : SP\_2017\_NA0010\_131\_6\_20170417\_00006.jpg

Looking south at downstream side of structure.

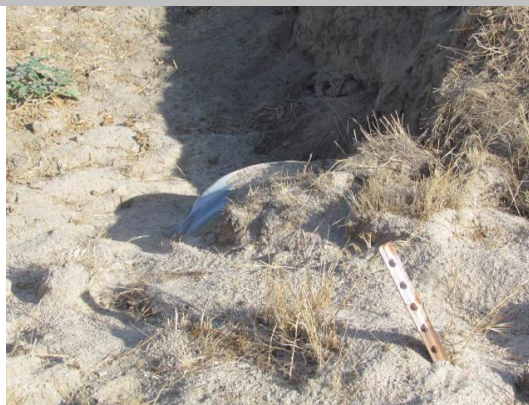
Photo 4 of 6 : SP\_2017\_NA0010\_131\_6\_20170417\_00007.jpg

Looking at corrugated pipe on north end on upstream side of structure.

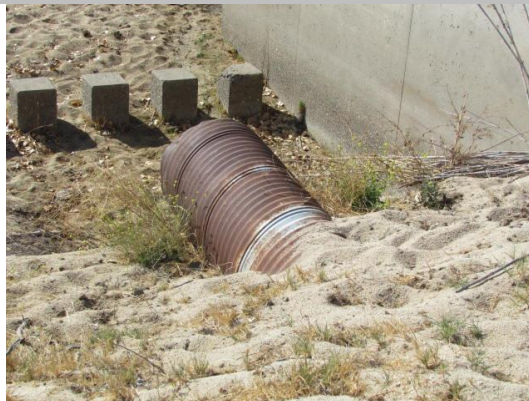
Photo 5 of 6 : SP\_2017\_NA0010\_131\_6\_20170417\_00008.jpg

Looking at corrugated pipe on north end on downstream side of structure.

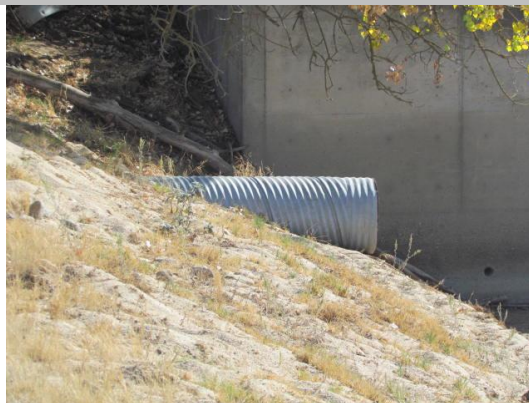
Photo 6 of 6 : SP\_2017\_NA0010\_131\_6\_20170417\_00009.jpg

LM Start	1.14	Rating **	A/W	Issue No.	6 (cont)	
LM End	1.14	Issue Type +	En	Location *	WS	
Category	Earthen Levee			GPS Latitude/Longitude		
				Start		End
Item	Encroachments			37.045541 °		37.045541 °
				-120.430014 °		-120.430014 °
DWR ID	DWR_NA0010_13_f_2015_6					
Comment Code						
WL : Wall						
Inspector Comment						
Sand dam has blow out due to water flow.

Looking at corrugated pipe on south end on downstream side of structure.

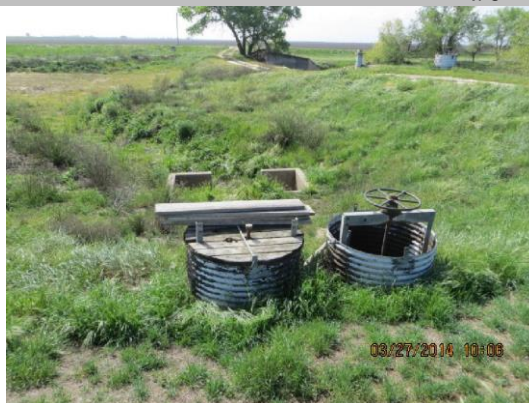
Photo 1 of 3 : UCIP\_SP\_2017\_39877\_59385.jpg

LM Start	1.14	Rating **	M	Issue No.	9
LM End	1.14	Issue Type +	En	Location *	WS
Category	Supplemental			GPS Latitude/Longitude	
				Start	End
Item	DWR UCIP Field Study			37.045872 °	37.045872 °
				-120.430070 °	-120.430070 °
DWR ID

Comment Code					
Inspector Comment					
FS_ID:39877 DS_ID:19727 EP_NO: N/A Repair Type: Non-Urgent Crossing Status: Found UCIP Comments: Appears abandoned and if so should be done so properly. Pipe filled with soil on WS at outlet. Actuator missing from slide gate on WS shoulder. FIELD_STRUCT_DESC: 1 of 2: 36-inch C.M. stormdrain pipe through the levee, 12.3 feet below the crown. Slide gate inside 48-inch C.M. pipe riser in waterward slope. Concrete distribution box (6x12-foot) on landward side. (USACE-1967). 7'X14' concrete outlet structure on WS toe. This entry matches the Drainage or Irrigation Structure referenced in O&M manual (HLM 1.14). FS Date: 3/27/2014

Slide gate in CMP riser on WS shoulder.

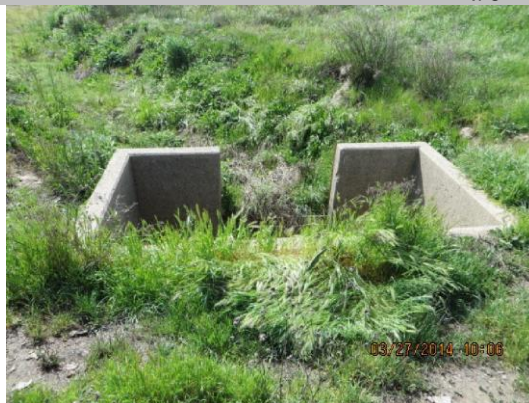
Photo 2 of 3 : UCIP\_SP\_2017\_39877\_59384.jpg

Comment Code						
Inspector Comment						
FS_ID:39877 DS_ID:19727 EP_NO: N/A Repair Type: Non-Urgent Crossing Status: Found UCIP Comments: Appears abandoned and if so should be done so properly. Pipe filled with soil on WS at outlet. Actuator missing from slide gate on WS shoulder. FIELD_STRUCT_DESC: 1 of 2: 36-inch C.M. stormdrain pipe through the levee, 12.3 feet below the crown. Slide gate inside 48-inch C.M. pipe riser in waterward slope. Concrete distribution box (6x12-foot) on landward side. (USACE-1967). 7'X14' concrete outlet structure on WS toe. This entry matches the Drainage or Irrigation Structure referenced in O&M manual (HLM 1.14). FS Date: 3/27/2014

Concrete box on WS toe.

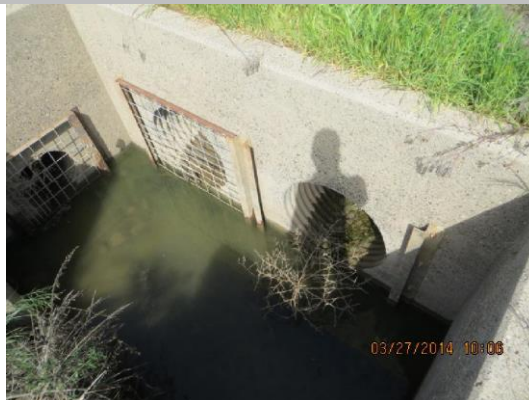
Photo 3 of 3 : UCIP\_SP\_2017\_39877\_59389.jpg

LM Start	<b>1.14</b>	Rating **	M	Issue No.	<b>9 (cont)</b>
LM End	<b>1.14</b>	Issue Type +	En	Location *	WS

Concrete box on WS toe.

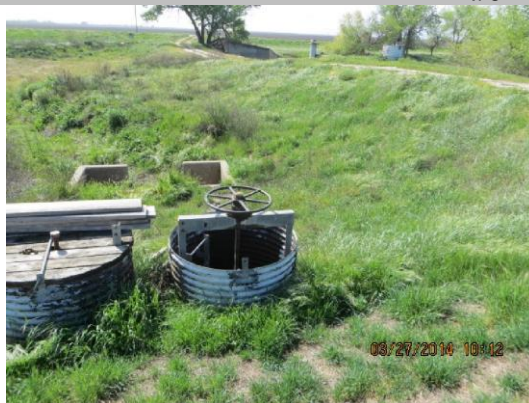
Photo 1 of 3 : UCIP\_SP\_2017\_39524\_59390.jpg

LM Start	1.14	Rating **	M	Issue No.	10
LM End	1.14	Issue Type +	En	Location *	WS
Category	Supplemental			GPS Latitude/Longitude	
				Start	End
Item	DWR UCIP Field Study			37.045870 °	37.045870 °
				-120.430080 °	-120.430080 °
DWR ID					
Comment Code					
Inspector Comment					
FS_ID:39524 DS_ID:19908 EP_NO: N/A Repair Type: Non-Urgent Crossing Status: Found UCIP Comments: No lid on riser at WS shoulder could be safety issue. FIELD_STRUCT_DESC: 2 of 2: 36-inch C.M. stormdrain pipe through the levee, 12.3 feet below the crown. Slide gate inside 48-inch C.M. pipe riser in waterward slope. Concrete distribution box (6x12-foot) on landward side. 7'X14' concrete distribution box on WS toe (USACE-1967). This entry matches the Drainage or Irrigation Structure referenced in O&M manual (HLM 1.14). FS Date: 3/27/2014

Slide gate in CMP riser without at lid on WS shoulder.

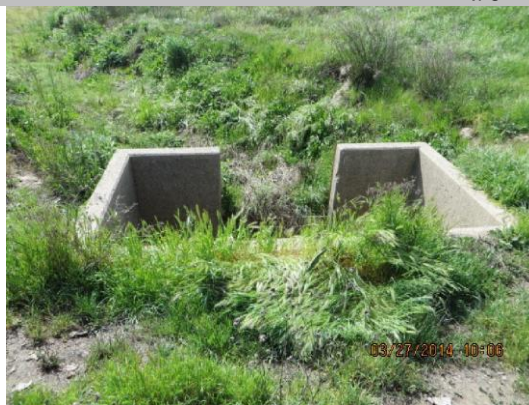
Photo 2 of 3 : UCIP\_SP\_2017\_39524\_59392.jpg

Concrete distribution box on WS toe.

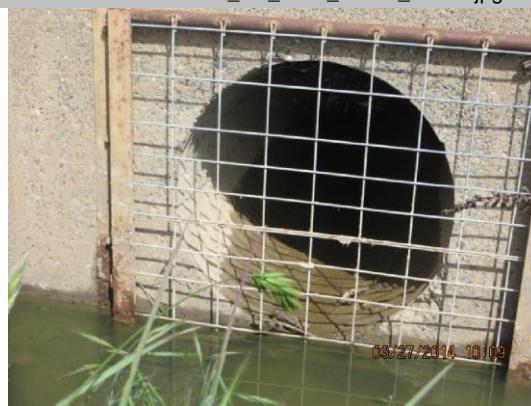
Photo 3 of 3 : UCIP\_SP\_2017\_39524\_59391.jpg

LM Start	1.14	Rating **	M	Issue No.	10 (cont)	
LM End	1.14	Issue Type +	En	Location *	WS	
Category	Supplemental			GPS Latitude/Longitude		
				Start	End	
Item	DWR UCIP Field Study			37.045870 °	37.045870 °	
				-120.430080 °	-120.430080 °	
DWR ID						
Comment Code						
Inspector Comment						
FS_ID:39524 DS_ID:19908 EP_NO: N/A Repair Type: Non-Urgent Crossing Status: Found UCIP Comments: No lid on riser at WS shoulder could be safety issue. FIELD_STRUCT_DESC: 2 of 2: 36-inch C.M. stormdrain pipe through the levee, 12.3 feet below the crown. Slide gate inside 48-inch C.M. pipe riser in waterward slope. Concrete distribution box (6x12-foot) on landward side. 7'X14' concrete distribution box on WS toe (USACE-1967). This entry matches the Drainage or Irrigation Structure referenced in O&M manual (HLM 1.14). FS Date: 3/27/2014

Pipe at outlet on WS toe.

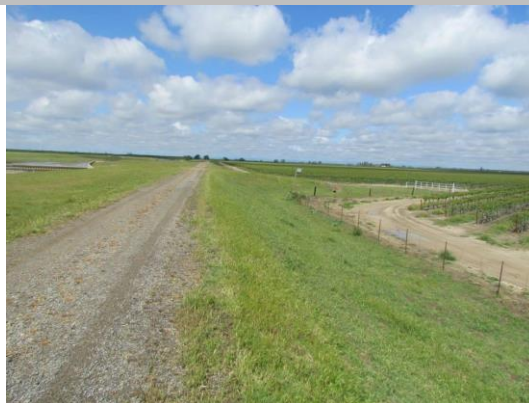
Photo 1 of 1 : SP\_2017\_NA0010\_132\_4\_20170425\_00009.jpg

LM Start	0.00	Rating **	M	Issue No.	4
LM End	1.26	Issue Type +	Ma	Location *	LS
Category	Earthen Levee			GPS Latitude/Longitude	
				Start	End
Item	Vegetation			37.032290 °	37.045455 °
				-120.441275 °	-120.427673 °
DWR ID	DWR_NA0010_14_s_2017_4				
Comment Code					
V1 : Control annual grass and weeds on the levee slopes and easements.					
Inspector Comment

Looking at typical view of landward slope.

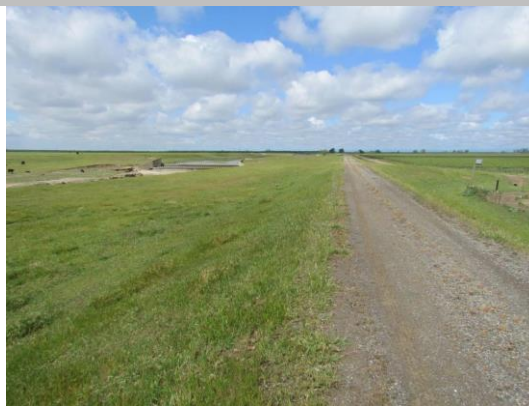
Photo 1 of 1 : SP\_2017\_NA0010\_132\_5\_20170425\_00010.jpg

LM Start	0.00	Rating **	M	Issue No.	5
LM End	1.26	Issue Type +	Ma	Location *	WS
Category	Earthen Levee			GPS Latitude/Longitude	
				Start	End
Item	Vegetation			37.032290 °	37.045455 °
				-120.441275 °	-120.427673 °
DWR ID	DWR_NA0010_14_s_2017_5				
Comment Code					
V1 : Control annual grass and weeds on the levee slopes and easements.					
Inspector Comment

Looking at typical view of waterward slope.

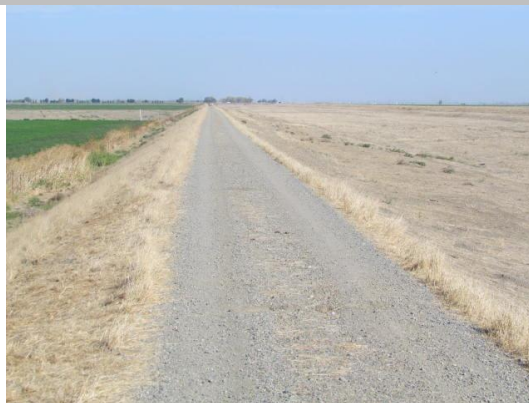
Photo 1 of 1 : SP\_2017\_NA0010\_132\_2\_20170417\_00001.jpg

LM Start	0.00	Rating **	M	Issue No.	2
LM End	1.26	Issue Type +	Ma	Location *	CR
Category	Earthen Levee			GPS Latitude/Longitude	
				Start	End
Item	Crown Surface / Depressions / Rutting			37.032379 °	37.045404 °
				-120.441265 °	-120.427749 °
DWR ID	DWR_NA0010_14_f_2012_2				
Comment Code					
C3 : Add appropriate gravel or road base. Grade and compact.					
Inspector Comment					
Control vegetation on levee crown.

Looking at typical view of levee crown.

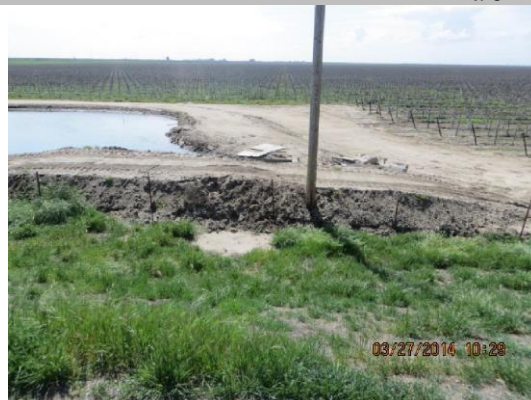
Photo 3 of 3 : UCIP\_SP\_2017\_39526\_59397.jpg

Comment Code					
Inspector Comment					
FS_ID:39526 DS_ID:19909 EP_NO: N/A Repair Type: Non-Urgent Crossing Status: Found UCIP Comments: Lid should be installed on CMP riser on WS slope, could be a safety hazard. Also dense vegetation limits the inspector's visibility to identify signs of pipe failure (leaks) along the slope. Recommend removing vegetation along pipe alignment to conduct proper inspection of structure. FIELD_STRUCT_DESC: 36-inch CM pipe through levee, 10-feet below crown. Slide gate inside 48-inch CM pipe riser in waterward slope. Concrete distribution box (6'X7') at toe of waterward slope. Slots for wooden flashboard on waterward side of box. 7'X9' Concrete distribution box on the landward side 20-feet from toe. (USACE-1967). This entry matches the Drainage or Irrigation Structure referenced in O&M manual (HLM 1.15). FS Date: 3/27/2014

Concrete distribution box visible next to power pole off LS toe.

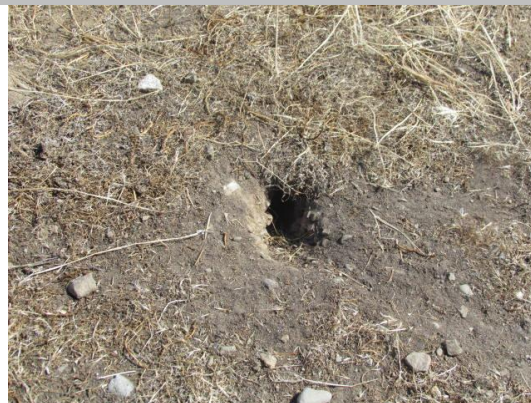
Photo 1 of 1 : SP\_2017\_NA0010\_132\_79\_20170417\_00002.jpg

LM Start	1.24	Rating **	M	Issue No.	79
LM End	1.24	Issue Type +	Ma	Location *	LS
Category	Earthen Levee			GPS Latitude/Longitude	
				Start	End
Item	Animal Control			37.045343 °	37.045343 °
				-120.428007 °	-120.428007 °
DWR ID	DWR_NA0010_14_s_2015_79				
Comment Code					
A3 : No rodents visible, but rodent burrows visible; need to backfill and compact or grout burrows.					
Inspector Comment					
Noted several rodent holes on landward at this location.

Looking at typical view of rodent holes on landward slope.

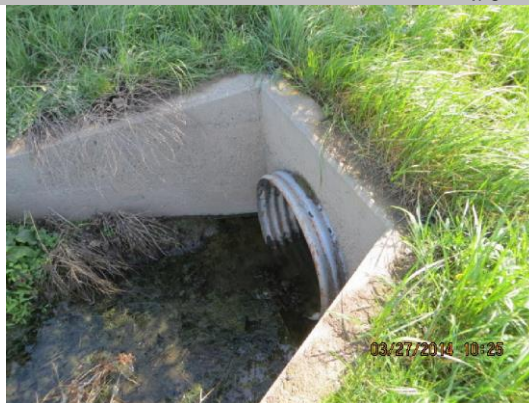
Photo 1 of 3 : UCIP\_SP\_2017\_32828\_59402.jpg

LM Start	1.26	Rating **	A/W	Issue No.	81
LM End	1.26	Issue Type +	Ma	Location *	LS
Category	Supplemental			GPS Latitude/Longitude	
				Start	End
Item	DWR UCIP LMA Responsibility			37.045383 °	37.045383 °
				-120.427754 °	-120.427754 °
DWR ID					
Comment Code					
Inspector Comment					
FS_ID:32828 DS_ID:19910 EP_NO: N/A Repair Type: No Action Needed Crossing Status: Found UCIP Comments: FIELD_STRUCT_DESC: 36-inch CM stormdrainpipe through levee, 9.0 feet below crown. Slide gate inside 42-inch CM pipe riser in the waterward slope. Concrete "U" headwall on the waterward end. Pipe terminates into concrete ditch on the landward side. (USACE-1967). This entry matches the Drainage or Irrigation Structure referenced in O&M manual (HLM 1.26). FS Date: 3/27/2014

Concrete U-shaped headwall on Ws toe.

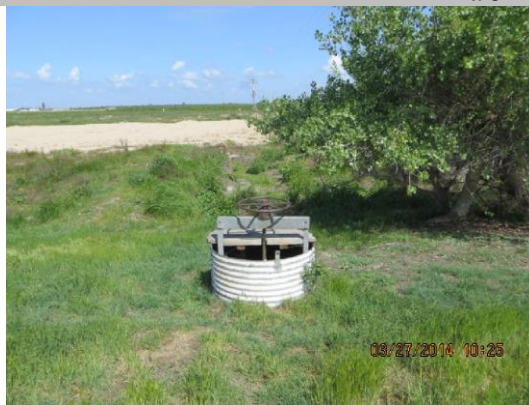
Photo 2 of 3 : UCIP\_SP\_2017\_32828\_59401.jpg

slidegate in CMP riser on WS slope.

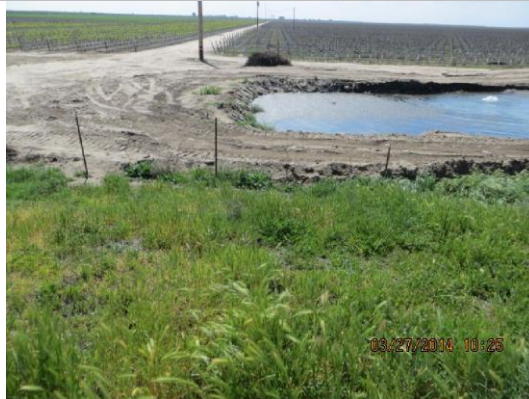
Photo 3 of 3 : UCIP\_SP\_2017\_32828\_59400.jpg

LM Start	1.26	Rating **	A/W	Issue No.	81 (cont)
LM End	1.26	Issue Type +	Ma	Location *	LS
Category	Supplemental			GPS Latitude/Longitude	
				Start	End
Item	DWR UCIP LMA Responsibility			37.045383 °	37.045383 °
				-120.427754 °	-120.427754 °
DWR ID					
Comment Code					
Inspector Comment					
FS_ID:32828 DS_ID:19910 EP_NO: N/A Repair Type: No Action Needed Crossing Status: Found UCIP Comments: FIELD_STRUCT_DESC: 36-inch CM stormdrainpipe through levee, 9.0 feet below crown. Slide gate inside 42-inch CM pipe riser in the waterward slope. Concrete "U" headwall on the waterward end. Pipe terminates into concrete ditch on the landward side. (USACE-1967). This entry matches the Drainage or Irrigation Structure referenced in O&M manual (HLM 1.26). FS Date: 3/27/2014

Inlet assumed to be within irrigation structure off LS toe.

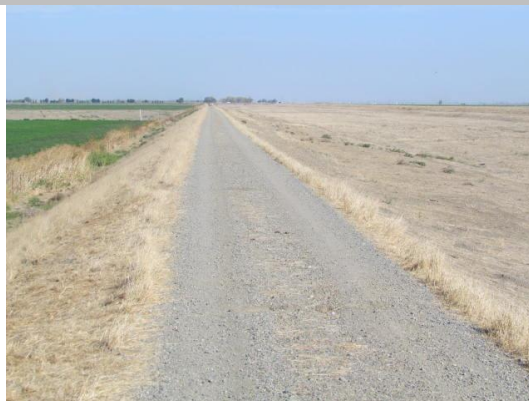
Photo 1 of 2 : SP\_2017\_NA0010\_133\_11\_20170417\_00002.jpg

LM Start	0.01	Rating **	M	Issue No.	11
LM End	1.99	Issue Type +	Ma	Location *	CR
Category	Earthen Levee			GPS Latitude/Longitude	
				Start	End
Item	Crown Surface / Depressions / Rutting			36.996547 °	36.996587 °
				-120.410220 °	-120.374503 °
DWR ID	DWR_NA0010_15_s_2012_11				
Comment Code					
C1 : Add appropriate material and re-grade the levee to bring the crown above the design elevation.					
Inspector Comment					
Control vegetation on levee crown.

Looking east at typical view of levee in compliance with standards. Fall 2015

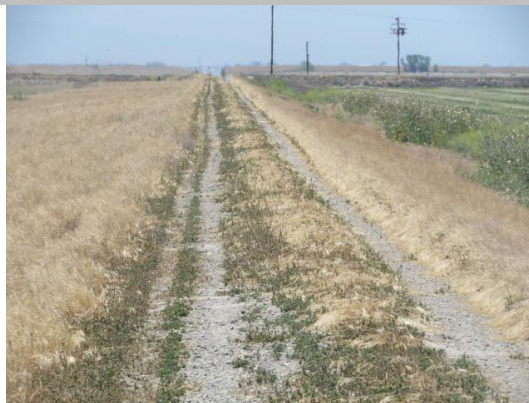
Photo 2 of 2 : SP\_2017\_NA0010\_133\_11\_20170417\_00003.jpg

LM Start	0.01	Rating **	M	Issue No.	11 (cont)	
LM End	1.99	Issue Type +	Ma	Location *	CR	
Category	Earthen Levee			GPS Latitude/Longitude		
				Start		End
Item	Crown Surface / Depressions / Rutting			36.996547 °		36.996587 °
				-120.410220 °		-120.374503 °
DWR ID	DWR_NA0010_15_s_2012_11					
Comment Code						
C1 : Add appropriate material and re-grade the levee to bring the crown above the design elevation.						
Inspector Comment						
Control vegetation on levee crown.

Looking east at vegetation on levee crown. Spring 2015

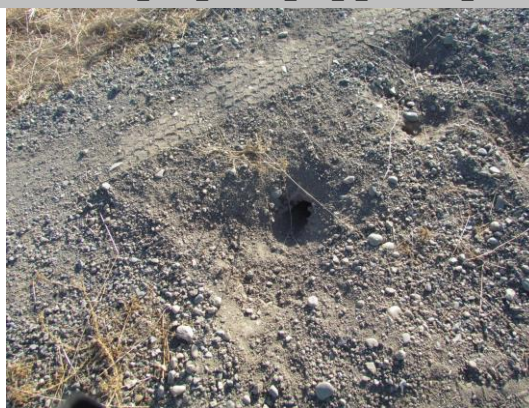
Photo 1 of 1 : SP\_2017\_NA0010\_133\_3\_20170417\_00001.jpg

LM Start	0.37	Rating **	M	Issue No.	3
LM End	0.37	Issue Type +	Ma	Location *	CR
Category	Earthen Levee			GPS Latitude/Longitude	
				Start	End
Item	Animal Control			36.996550 °	36.996550 °
				-120.403647 °	-120.403647 °
DWR ID	DWR_NA0010_15_f_2016_3				
Comment Code					
A3 : No rodents visible, but rodent burrows visible; need to backfill and compact or grout burrows.					
Inspector Comment					
Notice several rodent holes on levee crown.

Looking at typical rodent holes on levee crown.

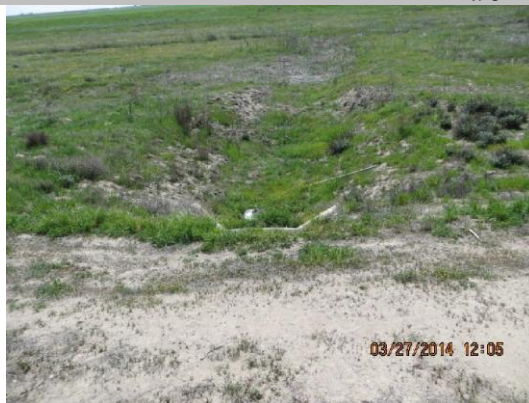
Photo 1 of 3 : UCIP\_SP\_2017\_32838\_59448.jpg

LM Start	0.48	Rating **	A/W	Issue No.	12
LM End	0.48	Issue Type +	Ma	Location *	CR
Category	Supplemental			GPS Latitude/Longitude	
				Start	End
Item	DWR UCIP LMA Responsibility			36.996551 °	36.996551 °
				-120.401737 °	-120.401737 °
DWR ID					
Comment Code					
Inspector Comment					
FS_ID:32838					
DS_ID:19911					
EP_NO: N/A					
Repair Type: No Action Needed					
Crossing Status: Found					
UCIP Comments:					
FIELD_STRUCT_DESC: 30-inch square R.C.B.C. stormdrain through the levee, 10.1 feet below the crown. Concrete "U" headwall on the waterward end. Flap gate on the waterward end. Concrete headwall on landward end. (USACE-1967). This entry matches the Drainage or Irrigation Structure referenced in O&M manual (HLM 0.48).					
FS Date: 3/27/2014

Concrete headwall on WS toe.

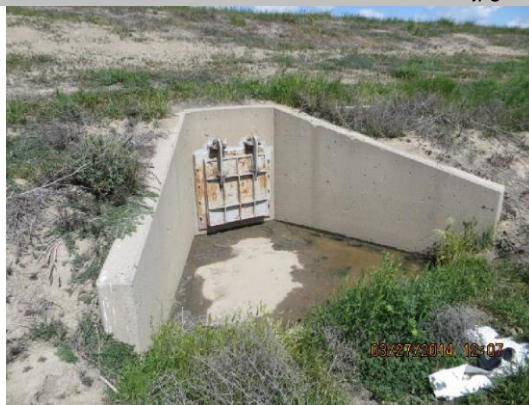
Photo 2 of 3 : UCIP\_SP\_2017\_32838\_59449.jpg

Flapgate on Concrete headwall at WS toe.

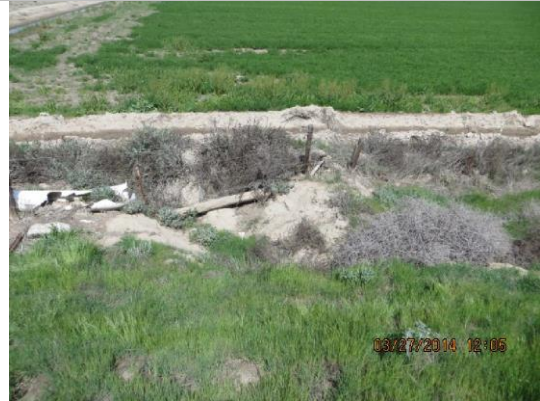
Photo 3 of 3 : UCIP\_SP\_2017\_32838\_59447.jpg

LM Start	0.48	Rating **	A/W	Issue No.	12 (cont)	
LM End	0.48	Issue Type +	Ma	Location *	CR	
Category	Supplemental			GPS Latitude/Longitude		
				Start		End
Item	DWR UCIP LMA Responsibility			36.996551 °		36.996551 °
				-120.401737 °		-120.401737 °
DWR ID						
Comment Code						
Inspector Comment						
FS_ID:32838						
DS_ID:19911						
EP_NO: N/A						
Repair Type: No Action Needed						
Crossing Status: Found						
UCIP Comments:						
FIELD_STRUCT_DESC: 30-inch square R.C.B.C. stormdrain through the levee, 10.1 feet below the crown. Concrete "U" headwall on the waterward end. Flap gate on the waterward end. Concrete headwall on landward end. (USACE-1967). This entry matches the Drainage or Irrigation Structure referenced in O&M manual (HLM 0.48).						
FS Date: 3/27/2014

Concrete headwall on LS toe.

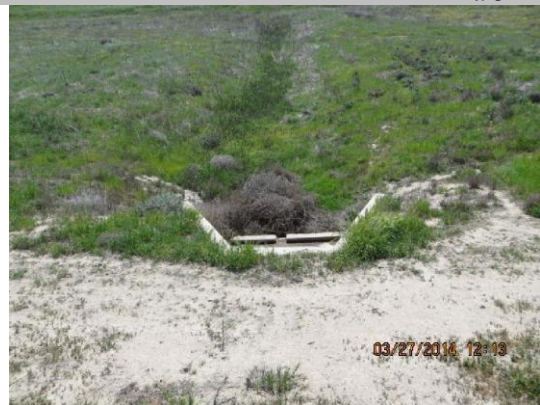
Photo 1 of 3 : UCIP\_SP\_2017\_39527\_59452.jpg

Comment Code					
Inspector Comment					
FS_ID:39527 DS_ID:19912 EP_NO: N/A Repair Type: Non-Urgent Crossing Status: Found UCIP Comments: Dense vegetation limits the inspector's visibility to identify signs of pipe failure (leaks) along the landward slope. Recommend removing vegetation along pipe alignment to conduct proper inspection of structure. FIELD_STRUCT_DESC: 30-inch square R.C.B.C. through the levee, 8.5 feet below the crown. Concrete "U" headwall on the waterward end. Flap gate on the waterward end. Concrete headwall on the landward end. (USACE-1967). This entry matches the Drainage or Irrigation Structure referenced in O&M manual (HLM 1.01). FS Date: 3/27/2014

Concrete headwall on WS toe.

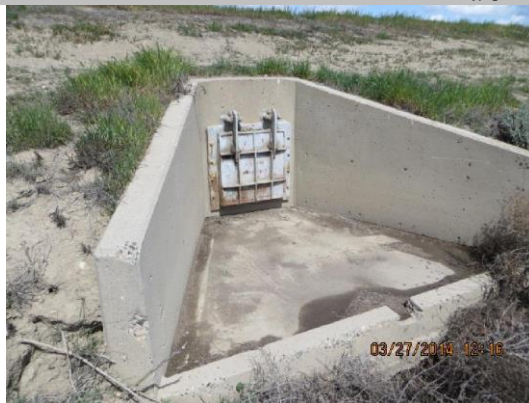
Photo 2 of 3 : UCIP\_SP\_2017\_39527\_59453.jpg

Flapgate on concrete headwall at WS toe.

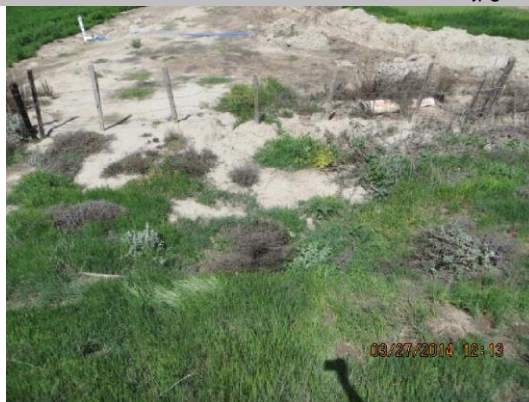
Photo 3 of 3 : UCIP\_SP\_2017\_39527\_59451.jpg

FS\_ID:39527  
DS\_ID:19912  
EP\_NO: N/A  
Repair Type: Non-Urgent  
Crossing Status: Found  
UCIP Comments: Dense vegetation limits the inspector's visibility to identify signs of pipe failure (leaks) along the landward slope. Recommend removing vegetation along pipe alignment to conduct proper inspection of structure.  
FIELD\_STRUCT\_DESC: 30-inch square R.C.B.C. through the levee, 8.5 feet below the crown. Concrete "U" headwall on the waterward end. Flap gate on the waterward end. Concrete headwall on the landward end. (USACE-1967). This entry matches the Drainage or Irrigation Structure referenced in O&M manual (HLM 1.01).  
FS Date: 3/27/2014

Concrete headwall on LS toe.

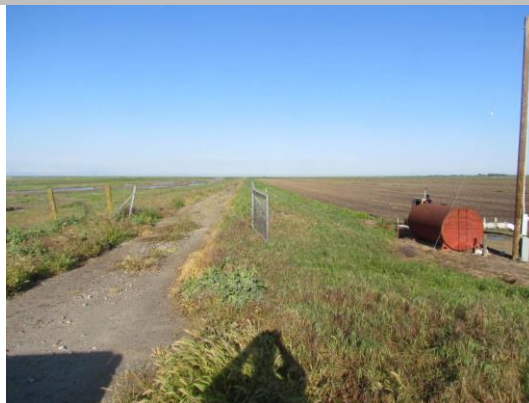
Photo 1 of 1 : SP\_2017\_NA0010\_133\_7\_20170425\_00014.jpg

LM Start	1.51	Rating **	U	Issue No.	7
LM End	2.03	Issue Type +	Ma	Location *	LS
Category	Earthen Levee			GPS Latitude/Longitude	
				Start	End
Item	Vegetation			36.996602 °	36.996577 °
				-120.383125 °	-120.373762 °
DWR ID	DWR_NA0010_15_s_2017_7				
Comment Code					
V2 : Remove the wild growth other than native grasses from the levee slopes.					
Inspector Comment

Looking downstream at dense veg on landward slope.

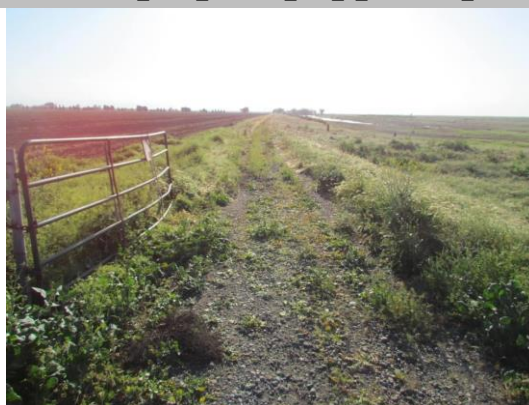
Photo 1 of 1 : SP\_2017\_NA0010\_133\_8\_20170425\_00013.jpg

LM Start	1.51	Rating **	U	Issue No.	8
LM End	2.03	Issue Type +	Ma	Location *	WS
Category	Earthen Levee			GPS Latitude/Longitude	
				Start	End
Item	Vegetation			36.996602 °	36.996577 °
				-120.383125 °	-120.373762 °
DWR ID	DWR_NA0010_15_s_2017_8				
Comment Code					
V2 : Remove the wild growth other than native grasses from the levee slopes.					
Inspector Comment

Looking upstream at dense veg on waterward slope.

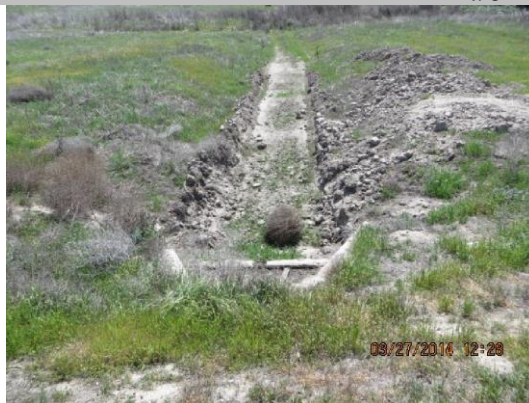
Photo 1 of 3 : UCIP\_SP\_2017\_32840\_59456.jpg

LM Start	1.53	Rating **	M	Issue No.	14
LM End	1.53	Issue Type +	Ma	Location *	WS
Category	Supplemental			GPS Latitude/Longitude	
				Start	End
Item	DWR UCIP LMA Responsibility			36.996582 °	36.996582 °
				-120.382757 °	-120.382757 °
DWR ID					
Comment Code					
Inspector Comment					
FS_ID:32840					
DS_ID:19913					
EP_NO: N/A					
Repair Type: Non-Urgent					
Crossing Status: Found					
UCIP Comments: Excessive vegetation at inlet on LS toe.					
FIELD_STRUCT_DESC: 30-inch square R.C.B.C. stormdrain through the levee, 8.9 feet below the crown. Concrete "U" headwall on the waterward end. Flap gate on the waterward end. Concrete headwall on the landward end. (USACE-1967). This entry matches the Drainage or Irrigation Structure referenced in O&M manual (HLM 1.53).					
FS Date: 3/27/2014

Concrete headwall on WS toe.

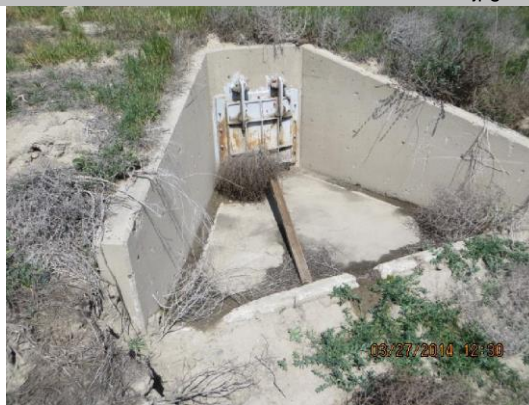
Photo 2 of 3 : UCIP\_SP\_2017\_32840\_59457.jpg

Flapgate on concrete headwall at WS toe.

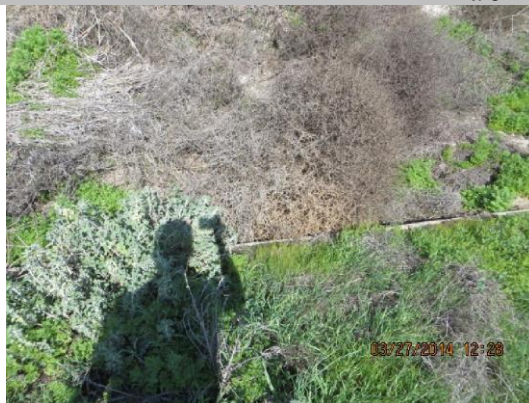
Photo 3 of 3 : UCIP\_SP\_2017\_32840\_59455.jpg

LM Start	1.53	Rating **	M	Issue No.	14 (cont)	
LM End	1.53	Issue Type +	Ma	Location *	WS	
Category	Supplemental			GPS Latitude/Longitude		
				Start		End
Item	DWR UCIP LMA Responsibility			36.996582 °		36.996582 °
				-120.382757 °		-120.382757 °
DWR ID						
Comment Code						
Inspector Comment						
FS_ID:32840						
DS_ID:19913						
EP_NO: N/A						
Repair Type: Non-Urgent						
Crossing Status: Found						
UCIP Comments: Excessive vegetation at inlet on LS toe.						
FIELD_STRUCT_DESC: 30-inch square R.C.B.C. stormdrain through the levee, 8.9 feet below the crown. Concrete "U" headwall on the waterward end. Flap gate on the waterward end. Concrete headwall on the landward end. (USACE-1967). This entry matches the Drainage or Irrigation Structure referenced in O&M manual (HLM 1.53).						
FS Date: 3/27/2014

Concrete headwall on LS toe. Note excessive vegetation buildup.

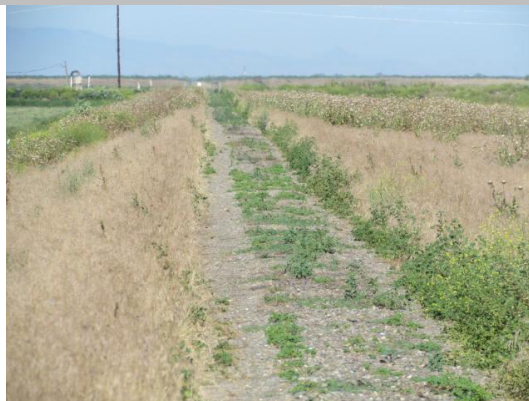
Photo 1 of 1 : SP\_2017\_NA0010\_134\_14\_20170417\_00004.jpg

LM Start	0.01	Rating **	M	Issue No.	14
LM End	1.96	Issue Type +	Ma	Location *	CR
Category	Earthen Levee			GPS Latitude/Longitude	
				Start	End
Item	Crown Surface / Depressions / Rutting			36.995388 °	36.995507 °
				-120.408738 °	-120.373592 °
DWR ID	DWR_NA0010_16_s_2012_14				
Comment Code					
C1 : Add appropriate material and re-grade the levee to bring the crown above the design elevation.					
Inspector Comment					
Control vegetation and regrade levee crown.

Looking at typical view of levee crown.

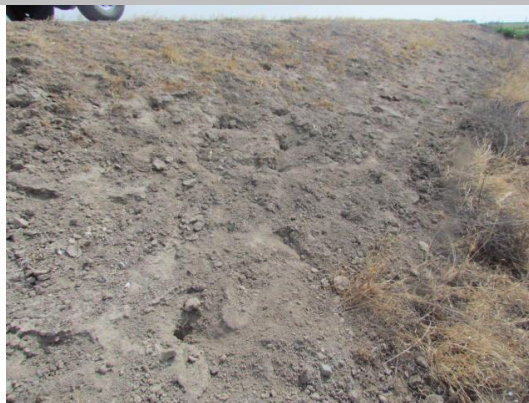
Photo 1 of 1 : SP\_2017\_NA0010\_134\_92\_20170417\_00005.jpg

LM Start	0.93	Rating **	M	Issue No.	92
LM End	0.93	Issue Type +	Ma	Location *	LS
Category	Earthen Levee			GPS Latitude/Longitude	
				Start	End
Item	Animal Control			36.995439 °	36.995439 °
				-120.392146 °	-120.392146 °
DWR ID	DWR_NA0010_16_s_2015_92				
Comment Code					
A3 : No rodents visible, but rodent burrows visible; need to backfill and compact or grout burrows.					
Inspector Comment					
Notice several rodent holes within this section.

Looking at several rodent holes on landward slope.

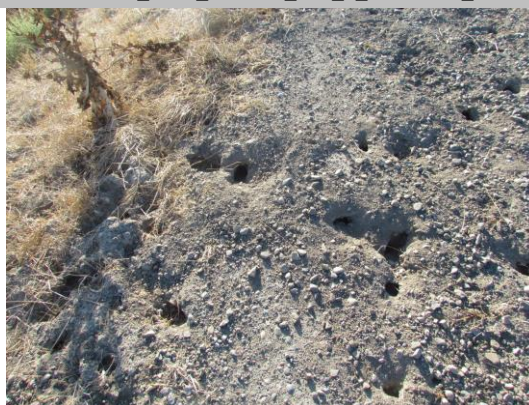
Photo 1 of 1 : SP\_2017\_NA0010\_134\_3\_20170417\_00003.jpg

LM Start	1.09	Rating **	U	Issue No.	3
LM End	1.09	Issue Type +	Ma	Location *	CR
Category	Earthen Levee			GPS Latitude/Longitude	
				Start	End
Item	Animal Control			36.995433 °	36.995433 °
				-120.389190 °	-120.389190 °
DWR ID	DWR_NA0010_16_f_2016_3				
Comment Code					
Inspector Comment					
Notice several rodent holes on levee crown.

Looking at several rodent holes and moles holes on levee crown.

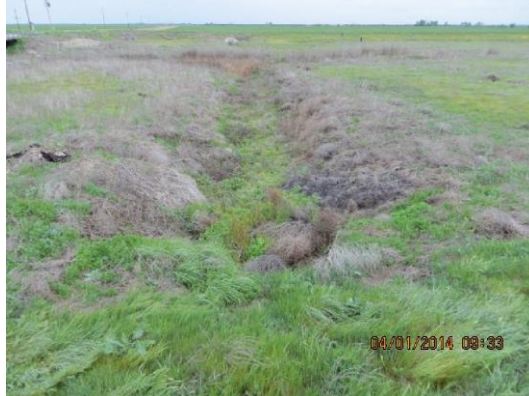
Photo 1 of 3 : UCIP\_SP\_2017\_39529\_59681.jpg

LM Start	1.44	Rating **	M	Issue No.	93	
LM End	1.44	Issue Type +	Ma	Location *	LS	
Category	Supplemental			GPS Latitude/Longitude		
				Start	End	
Item	DWR UCIP LMA Responsibility			36.995473 °	36.995473 °	
				-120.382872 °	-120.382872 °	
DWR ID						
Comment Code						
Inspector Comment						
FS_ID:39529 DS_ID:19915 EP_NO: N/A Repair Type: Non-Urgent Crossing Status: Found UCIP Comments: Dense vegetation buildup at landside toe-- recommend clearing. FIELD_STRUCT_DESC: 30-inch square R.C.B.C. through levee, 8.5 feet below crown. Concrete "U" headwall on waterward end. Two concrete cutoff walls. Flap gate on waterward side. Concrete headwall on landward end. (USACE-1967). This entry matches the Drainage or Irrigation Structure referenced in O&M manual (HLM 1.46). FS Date: 4/1/2014 8:12:00 AM

Concrete headwall on WS toe with channel.

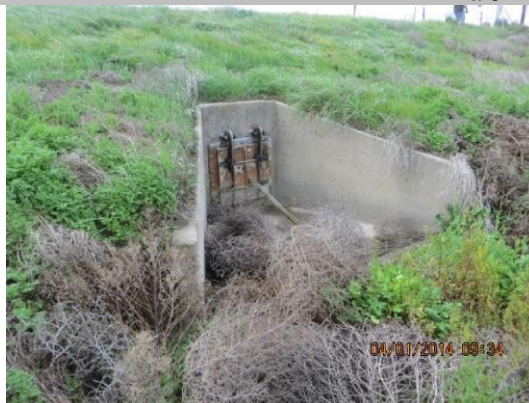
Photo 2 of 3 : UCIP\_SP\_2017\_39529\_59680.jpg

Flapgate on headwall at WS toe.

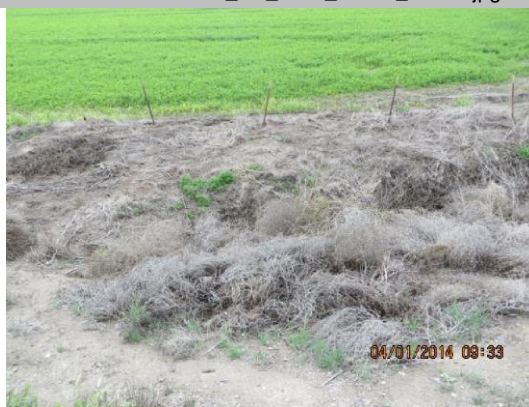
Photo 3 of 3 : UCIP\_SP\_2017\_39529\_59682.jpg

LM Start	1.44	Rating **	M	Issue No.	93 (cont)	
LM End	1.44	Issue Type +	Ma	Location *	LS	
Category	Supplemental			GPS Latitude/Longitude		
				Start		End
Item	DWR UCIP LMA Responsibility			36.995473 °		36.995473 °
				-120.382872 °		-120.382872 °
DWR ID						
Comment Code						
Inspector Comment						
FS_ID:39529 DS_ID:19915 EP_NO: N/A Repair Type: Non-Urgent Crossing Status: Found UCIP Comments: Dense vegetation buildup at landside toe-- recommend clearing. FIELD_STRUCT_DESC: 30-inch square R.C.B.C. through levee, 8.5 feet below crown. Concrete "U" headwall on waterward end. Two concrete cutoff walls. Flap gate on waterward side. Concrete headwall on landward end. (USACE-1967). This entry matches the Drainage or Irrigation Structure referenced in O&M manual (HLM 1.46). FS Date: 4/1/2014 8:12:00 AM

Concrete headwall on LS toe covered in vegetation/tumble weeds.

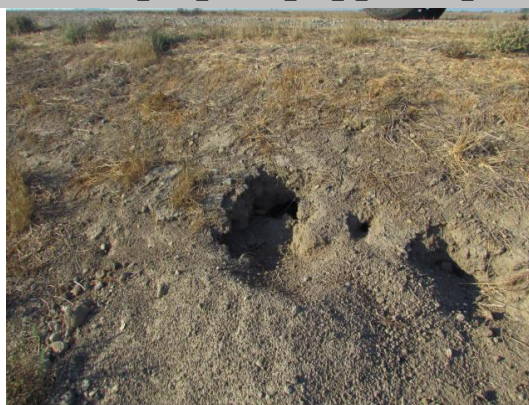
Photo 1 of 2 : SP\_2017\_NA0010\_134\_2\_20170417\_00001.jpg

LM Start	1.77	Rating **	U	Issue No.	2	
LM End	1.77	Issue Type +	Ma	Location *	LS	
Category	Earthen Levee			GPS Latitude/Longitude		
				Start		End
Item	Animal Control			36.995487 °		36.995487 °
				-120.377054 °		-120.377054 °
DWR ID	DWR_NA0010_16_f_2014_2					
Comment Code						
A3 : No rodents visible, but rodent burrows visible; need to backfill and compact or grout burrows.						
Inspector Comment						
Large rodent holes on landward slope.

Looking at large rodent holes on landward slope.

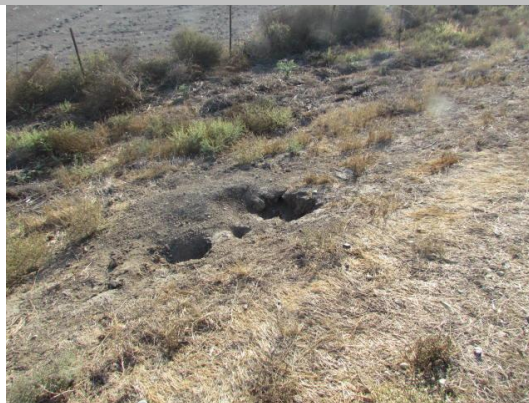
Photo 2 of 2 : SP\_2017\_NA0010\_134\_2\_20170417\_00002.jpg

Looking southwest at several rodent holes on landward slope.

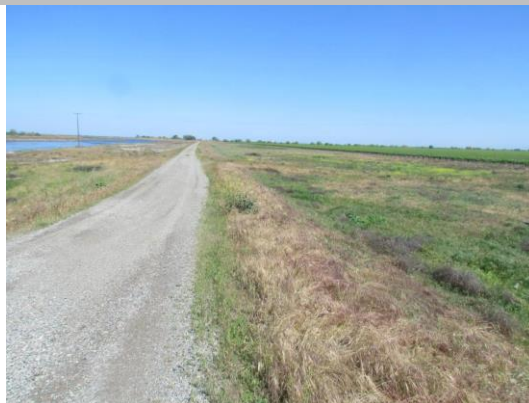
Photo 1 of 1 : SP\_2017\_NA0010\_135\_11\_20170425\_00034.jpg

LM Start	0.00	Rating **	M	Issue No.	11
LM End	16.09	Issue Type +	Ma	Location *	LS
Category	Earthen Levee			GPS Latitude/Longitude	
				Start	End
Item	Vegetation			36.976445 °	36.774417 °
				-120.374700 °	-120.283748 °
DWR ID	DWR_NA0010_17_f_2016_11				
Comment Code					
V1 : Control annual grass and weeds on the levee slopes and easements.					
Inspector Comment					
Dense vegetation (tumble weeds) on levee slope.

Looking at typical view of landward slope.

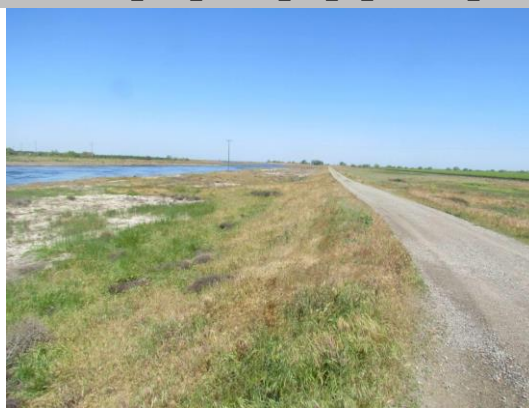
Photo 1 of 1 : SP\_2017\_NA0010\_135\_12\_20170425\_00033.jpg

LM Start	0.00	Rating **	M	Issue No.	12
LM End	16.09	Issue Type +	Ma	Location *	WS
Category	Earthen Levee			GPS Latitude/Longitude	
				Start	End
Item	Vegetation			36.976445 °	36.774417 °
				-120.374700 °	-120.283748 °
DWR ID	DWR_NA0010_17_f_2016_12				
Comment Code					
V1 : Control annual grass and weeds on the levee slopes and easements.					
Inspector Comment					
Dense vegetation (Tumble weeds) on levee slope.

Looking at typical view of waterward slope.

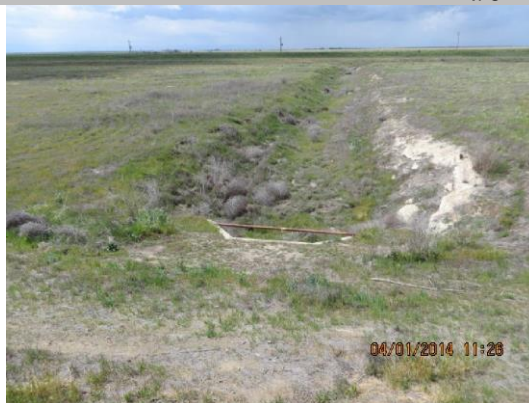
Photo 1 of 3 : UCIP\_SP\_2017\_39531\_59710.jpg

Comment Code					
Inspector Comment					
FS_ID:39531 DS_ID:19916 EP_NO: N/A Repair Type: Non-Urgent Crossing Status: Found UCIP Comments: Dense vegetation limits the inspector's visibility to identify signs of pipe failure (leaks) along the landward slope. Recommend removing vegetation along pipe alignment to conduct proper inspection of structure. FIELD_STRUCT_DESC: 48x60-inch R.C.B.C. through the levee, 14.6 feet below the crown. Concrete "U" headwall on the waterward end. Flap gate on the waterward end. Concrete headwall on the landward end. (USACE-1967). This entry matches the Drainage or Irrigation Structure referenced in O&M manual (HLM 2.58). FS Date: 4/1/2014

Concrete headwall at channel on WS toe.

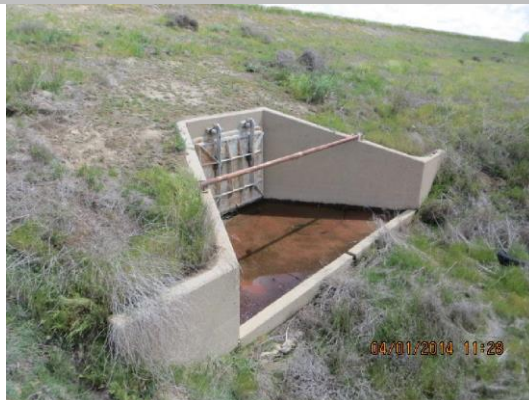
Photo 2 of 3 : UCIP\_SP\_2017\_39531\_59711.jpg

Flapgate on Concrete headwall at WS toe.

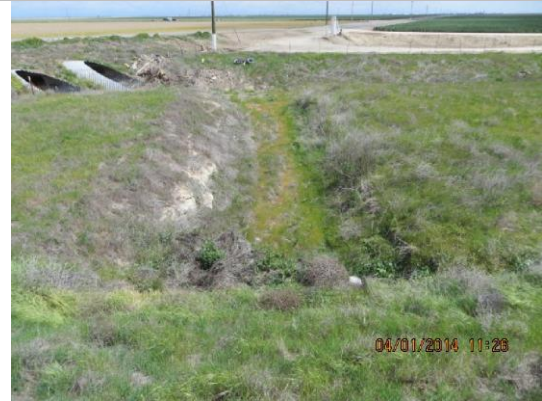
Photo 3 of 3 : UCIP\_SP\_2017\_39531\_59709.jpg

Comment Code						
Inspector Comment						
FS_ID:39531						
DS_ID:19916						
EP_NO: N/A						
Repair Type: Non-Urgent						
Crossing Status: Found						
UCIP Comments: Dense vegetation limits the inspector's visibility to identify signs of pipe failure (leaks) along the landward slope.						
Recommend removing vegetation along pipe alignment to conduct proper inspection of structure.						
FIELD_STRUCT_DESC: 48x60-inch R.C.B.C. through the levee, 14.6 feet below the crown. Concrete "U" headwall on the waterward end.						
Flap gate on the waterward end. Concrete headwall on the landward end. (USACE-1967). This entry matches the Drainage or Irrigation Structure referenced in O&M manual (HLM 2.58).						
FS Date: 4/1/2014

Concrete headwall at LS toe.

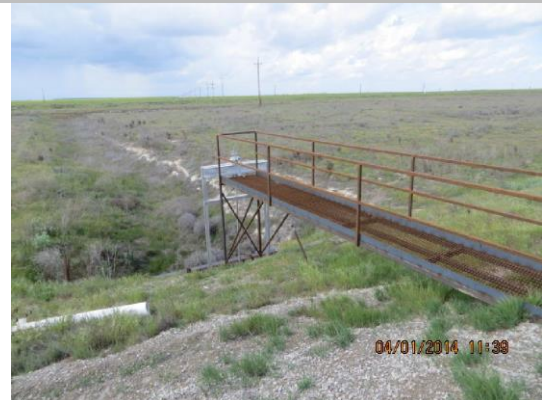
Photo 1 of 3 : UCIP\_SP\_2017\_32998\_59714.jpg

Comment Code					
Inspector Comment					
FS_ID:32998					
DS_ID:19921					
EP_NO: N/A					
Repair Type: No Action Needed					
Crossing Status: Found					
UCIP Comments:					
FIELD_STRUCT_DESC: 48x60-inch R.C.B.C. through the levee, 14.6 feet below the crown. Concrete "U" headwall on the waterward end. 36-inch weir structure on waterward side. Combination Flap gate/slidegate on the waterward toe (USACE-1967). Steel walkway to slide gate actuator on WS shoulder. This entry matches the Drainage or Irrigation Structure referenced in O&M manual (HLM 4.69). Cable winch, weir structure and external drainage system built under Permit No. 13587 (1984).					
FS Date: 4/1/2014

Steel walkway to slide gate actuator on WS shoulder.

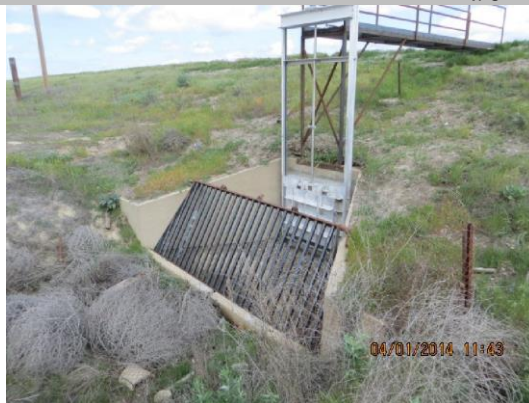
Photo 2 of 3 : UCIP\_SP\_2017\_32998\_59715.jpg

Combination flapgate/slidegate, concrete headwall, and metal screen at WS toe.

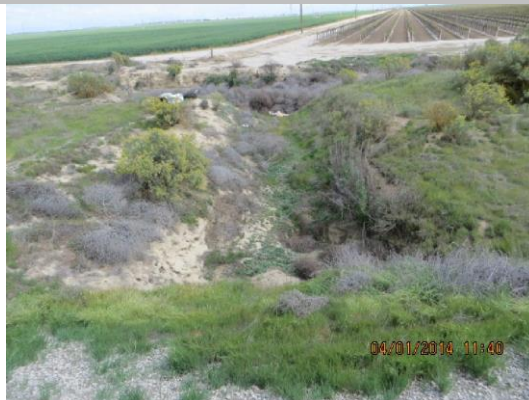
Photo 3 of 3 : UCIP\_SP\_2017\_32998\_59713.jpg

Concrete headwall on LS toe.

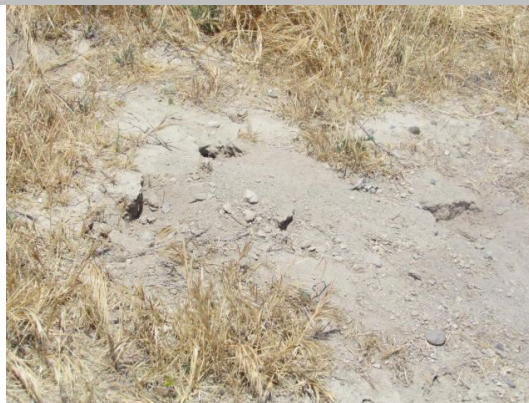
Photo 1 of 2 : SP\_2017\_NA0010\_135\_8\_20170417\_00005.jpg

LM Start	5.75	Rating **	M	Issue No.	8
LM End	5.90	Issue Type +	Ma	Location *	LS
Category	Earthen Levee			GPS Latitude/Longitude	
				Start	End
Item	Animal Control			36.908605 °	36.906507 °
				-120.331112 °	-120.330353 °
DWR ID	DWR_NA0010_17_s_2012_8				
Comment Code					
A1 : Exterminate rodents and backfill and compact or grout burrows.					
Inspector Comment					
Several rodent holes noted on landward slope.

Looking at several rodent holes on landward slope. (Spring 2015)

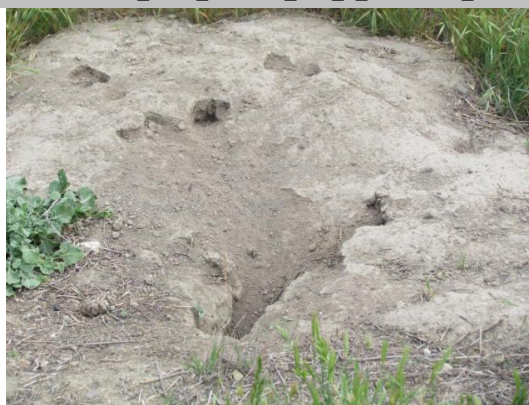
Photo 2 of 2 : SP\_2017\_NA0010\_135\_8\_20170417\_00006.jpg

Looking at several rodent holes on landside slope. (Fall 2014)

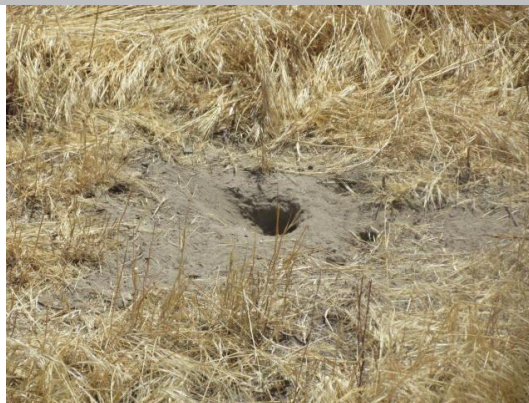
Photo 1 of 1 : SP\_2017\_NA0010\_135\_4\_20170417\_00003.jpg

LM Start	6.51	Rating **	M	Issue No.	4
LM End	6.60	Issue Type +	Ma	Location *	LS
Category	Earthen Levee			GPS Latitude/Longitude	
				Start	End
Item	Animal Control			36.898124 °	36.896943 °
				-120.326714 °	-120.326133 °
DWR ID	DWR_NA0010_17_s_2012_4				
Comment Code					
A1 : Exterminate rodents and backfill and compact or grout burrows.					
Inspector Comment					
Notice several rodent holes within this reach.

Looking at typical view of rodent holes on landward slope.

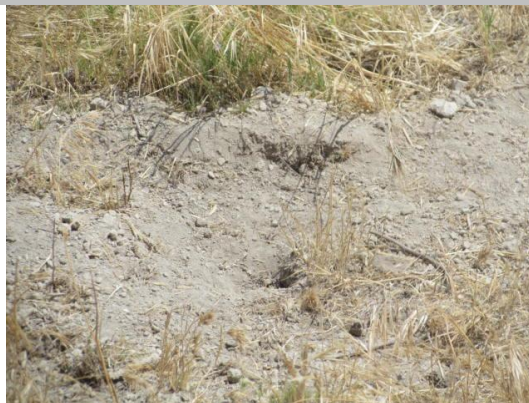
Photo 1 of 1 : SP\_2017\_NA0010\_135\_5\_20170417\_00004.jpg

LM Start	7.27	Rating **	M	Issue No.	5
LM End	7.38	Issue Type +	Ma	Location *	LS
Category	Earthen Levee			GPS Latitude/Longitude	
				Start	End
Item	Animal Control			36.887869 °	36.886341 °
				-120.321697 °	-120.320940 °
DWR ID	DWR_NA0010_17_s_2012_5				
Comment Code					
A3 : No rodents visible, but rodent burrows visible; need to backfill and compact or grout burrows.					
Inspector Comment					
Notice several rodent holes within this reach.

Looking at typical view of rodent holes on landward slope.
