**Flood Control Project Maintenance  
Levee Inspections**  
**LMA District Cover Sheet**  
**Spring 2017 Levee Inspection Results**

**Lower San Joaquin Levee District**

Waterway			Bank	Unit Miles
Unit No. 01 San Joaquin River			Right	22.52
	Spring (March - May)	Summer (June - August)	(September - November) Fall	Winter (December - February)
Unit Maintenance Rating (Fall Only)				
Date of Inspection	4/17/2017 - 4/20/2017			
DWR Inspector	Richard Willoughby			
Accompanied By

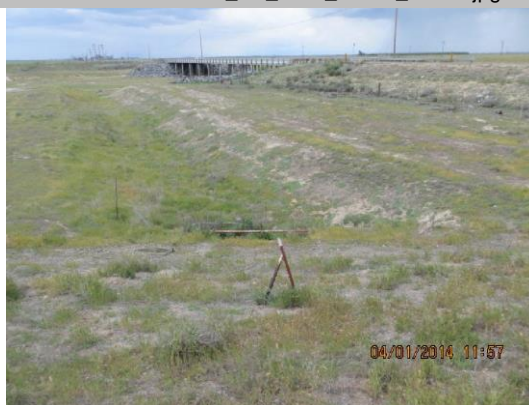
Photo 1 of 3 : UCIP\_SP\_2017\_32999\_59718.jpg

LM Start	8.37	Rating **	A/W	Issue No.	15
LM End	8.37	Issue Type +	Ma	Location *	LS
Category	Supplemental			GPS Latitude/Longitude	
				Start	End
Item	DWR UCIP LMA Responsibility			36.872358 °	36.872358 °
				-120.317170 °	-120.317170 °
DWR ID					
Comment Code					
Inspector Comment					
FS_ID:32999					
DS_ID:19922					
EP_NO: N/A					
Repair Type: No Action Needed					
Crossing Status: Found					
UCIP Comments:					
FIELD_STRUCT_DESC: 48x60-inch R.C.B.C. through the levee. 16.5 feet below the crown. Concrete "U" headwall on the waterward end. Flap gate on the waterward end. Concrete headwall on the landward end. (USACE-1967). This entry matches the Drainage or Irrigation Structure referenced in O&M manual (HLM 8.38).					
FS Date: 4/1/2014

Concrete headwall and channel on WS toe.

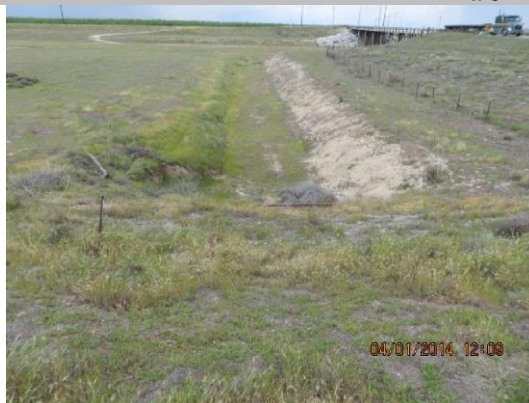
Photo 1 of 3 : UCIP\_SP\_2017\_39532\_59723.jpg

LM Start	9.88	Rating **	M	Issue No.	16
LM End	9.88	Issue Type +	Ma	Location *	LS
Category	Supplemental			GPS Latitude/Longitude	
				Start	End
Item	DWR UCIP LMA Responsibility			36.850703 °	36.850703 °
				-120.314154 °	-120.314154 °
DWR ID					
Comment Code					
Inspector Comment					
FS_ID:39532 DS_ID:19917 EP_NO: N/A Repair Type: Non-Urgent Crossing Status: Found UCIP Comments: Dense vegetation limits the inspector's visibility to identify signs of pipe failure (leaks) along the landward slope. Recommend removing vegetation along pipe alignment to conduct proper inspection of structure. FIELD_STRUCT_DESC: 48x60-inch R.C.B.C. through the levee, 15-feet below the crown. Concrete "U" headwall on the waterward end. Concrete headwall on landward end. (USACE-1967). This entry matches the Drainage or Irrigation Structure referenced in O&M manual (HLM 9.89). FS Date: 4/1/2014

Concrete headwall and channel on WS toe.

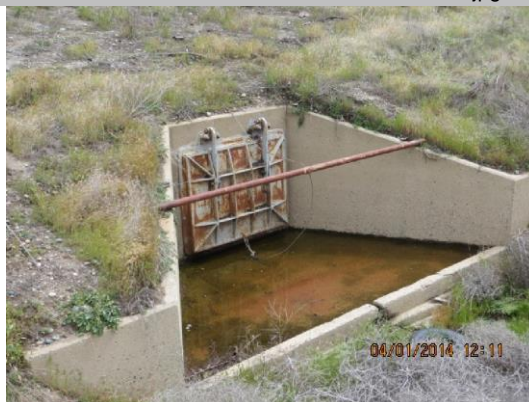
Photo 2 of 3 : UCIP\_SP\_2017\_39532\_59724.jpg

Flapgate on Concrete headwall at WS toe.

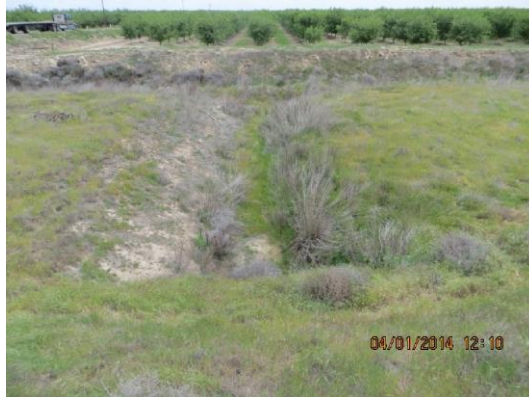
Photo 3 of 3 : UCIP\_SP\_2017\_39532\_59722.jpg

Comment Code						
Inspector Comment						
FS_ID:39532						
DS_ID:19917						
EP_NO: N/A						
Repair Type: Non-Urgent						
Crossing Status: Found						
UCIP Comments: Dense vegetation limits the inspector's visibility to						
identify signs of pipe failure (leaks) along the landward slope.						
Recommend removing vegetation along pipe alignment to conduct						
proper inspection of structure.						
FIELD_STRUCT_DESC: 48x60-inch R.C.B.C. through the levee, 15-						
feet below the crown. Concrete "U" headwall on the waterward end.						
Concrete headwall on landward end. (USACE-1967). This entry						
matches the Drainage or Irrigation Structure referenced in O&M manual						
(HLM 9.89).						
FS Date: 4/1/2014

Concrete headwall and channel on LS toe.

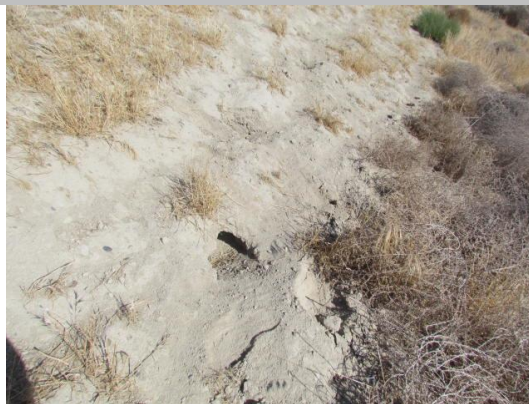
Photo 1 of 2 : SP\_2017\_NA0010\_135\_3\_20170417\_00001.jpg

LM Start	12.34	Rating **	M	Issue No.	3
LM End	12.38	Issue Type +	Ma	Location *	LS
Category	Earthen Levee			GPS Latitude/Longitude	
				Start	End
Item	Animal Control			36.820558 °	36.820000 °
				-120.300616 °	-120.300831 °
DWR ID	DWR_NA0010_17_s_2014_3				
Comment Code					
A3 : No rodents visible, but rodent burrows visible; need to backfill and compact or grout burrows.					
Inspector Comment					
Noted several rodent holes with this reach.

Looking at typical view of rodent holes on landward slope. Fall 2015

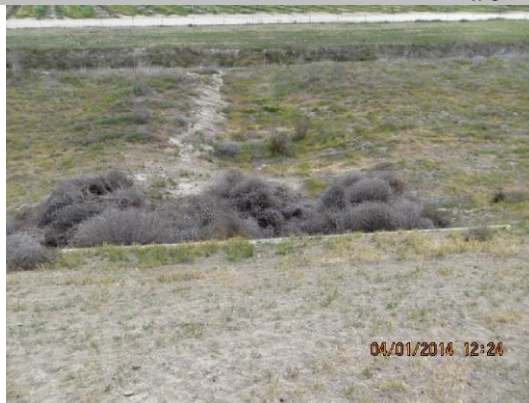
Photo 2 of 3 : UCIP\_SP\_2017\_39533\_59726.jpg

LM Start	13.29	Rating **	M	Issue No.	17 (cont)
LM End	13.29	Issue Type +	Ma	Location *	LS
Category	Supplemental			GPS Latitude/Longitude	
				Start	End
Item	DWR UCIP LMA Responsibility			36.807509 °	36.807509 °
				-120.306231 °	-120.306231 °
DWR ID					
Comment Code					
Inspector Comment					
FS_ID:39533					
DS_ID:19918					
EP_NO: N/A					
Repair Type: Non-Urgent					
Crossing Status: Found					
UCIP Comments: Some vegetation buildup at inlet--recommend clearing.					
FIELD_STRUCT_DESC: 48x60-inch R.C.B.C. through the levee, 15.3 feet below the crown. Concrete "U" headwall on the waterward end. Flap gate on the waterward end. Concrete headwall on the landward end. (USACE-1967). This entry matches the Drainage or Irrigation Structure referenced in O&M manual (HLM 13.30).					
FS Date: 4/1/2014

Concrete headwall on LS toe.

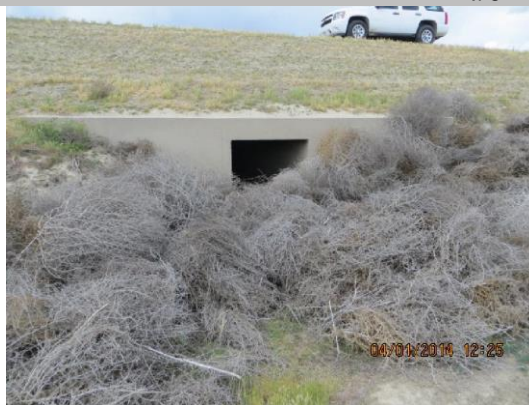
Photo 3 of 3 : UCIP\_SP\_2017\_39533\_59725.jpg

Concrete headwall on LS toe. Some vegetation buildup.

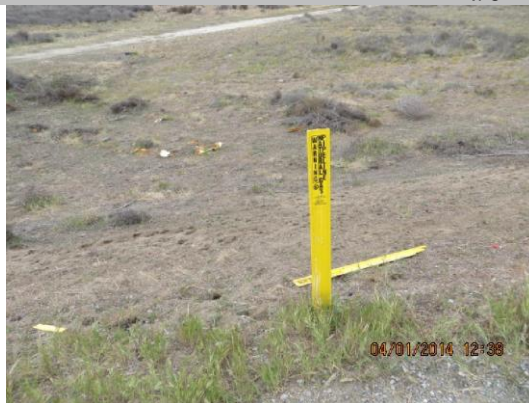
Photo 1 of 3 : UCIP\_SP\_2017\_41406\_71490.jpg

LM Start	14.38	Rating **	M	Issue No.	18
LM End	14.38	Issue Type +	En	Location *	LS
Category	Supplemental			GPS Latitude/Longitude	
				Start	End
Item	DWR UCIP Field Study			36.793318 °	36.793318 °
				-120.302138 °	-120.302138 °
DWR ID					
Comment Code					
Inspector Comment					
FS_ID:41406 DS_ID:24850 EP_NO: N/A Repair Type: Non-Urgent Crossing Status: Indicator Found UCIP Comments: No permit identified for this crossing. FIELD_STRUCT_DESC: Gas line through the levee at an unknown depth. Gas line markers on both shoulders. FS Date: 4/1/2014

Gasline marker on WS slope..

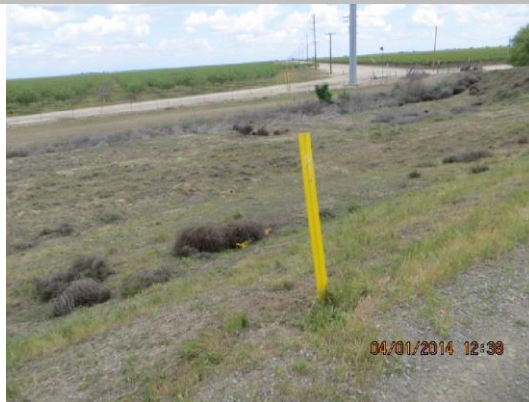
Photo 2 of 3 : UCIP\_SP\_2017\_41406\_71489.jpg

Gasline marker on LS shoulder.

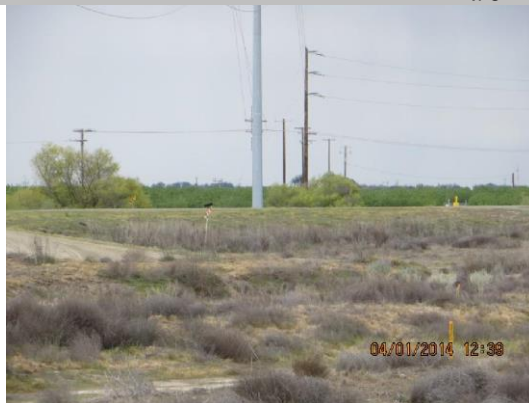
Photo 3 of 3 : UCIP\_SP\_2017\_41406\_71488.jpg

LM Start	14.38	Rating **	M	Issue No.	18 (cont)	
LM End	14.38	Issue Type +	En	Location *	LS	
Category	Supplemental			GPS Latitude/Longitude		
				Start		End
Item	DWR UCIP Field Study			36.793318 °		36.793318 °
				-120.302138 °		-120.302138 °
DWR ID						
Comment Code						
Inspector Comment						
FS_ID:41406 DS_ID:24850 EP_NO: N/A Repair Type: Non-Urgent Crossing Status: Indicator Found UCIP Comments: No permit identified for this crossing. FIELD_STRUCT_DESC: Gas line through the levee at an unknown depth. Gas line markers on both shoulders. FS Date: 4/1/2014

Gasline markers visible along right side of photo.

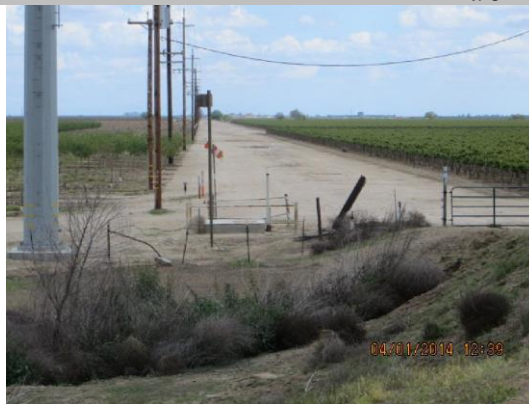
Photo 1 of 3 : UCIP\_SP\_2017\_50067\_59742.jpg

Comment Code					
Inspector Comment					
FS_ID:50067 DS_ID:19562 EP_NO: 18568 Repair Type: Non-Urgent Crossing Status: Indicator Found UCIP Comments: 7/20/2016 Marker visible on LS. WS marker missing. (DWR UCIP - omagana)4/01/2014 Need to contact owner to confirm and obtain status of crossing. Markers misleading--unable to confirm if markers correspond to this crossing. Need markers at levee. (DWR UCIP - omagana) FIELD_STRUCT_DESC: 30-inch steel gas pipeline through the levee, approximately 60 feet below the crown. Location markers are visible on the waterside (WS) and landside (LS). (Permit No. 18568, 2010 - Gill Ranch Storage LLC) FS Date: 7/20/2016

Gasline marker and concrete sump off LS toe.

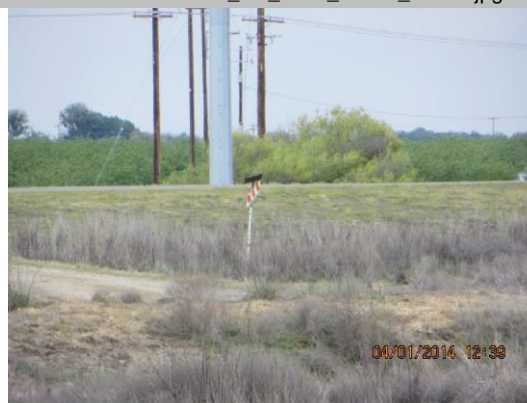
Photo 2 of 3 : UCIP\_SP\_2017\_50067\_59741.jpg

Item	DWR UCIP Field Study			36.793195 °		36.793195 °
				-120.302028 °		-120.302028 °
DWR ID						
Comment Code						
Inspector Comment						
FS_ID:50067 DS_ID:19562 EP_NO: 18568 Repair Type: Non-Urgent Crossing Status: Indicator Found UCIP Comments: 7/20/2016 Marker visible on LS. WS marker missing. (DWR UCIP - omagana)4/01/2014 Need to contact owner to confirm and obtain status of crossing. Markers misleading--unable to confirm if markers correspond to this crossing. Need markers at levee. (DWR UCIP - omagana) FIELD_STRUCT_DESC: 30-inch steel gas pipeline through the levee, approximately 60 feet below the crown. Location markers are visible on the waterside (WS) and landside (LS). (Permit No. 18568, 2010 - Gill Ranch Storage LLC) FS Date: 7/20/2016

Gasline marker visible in channel off WS toe.

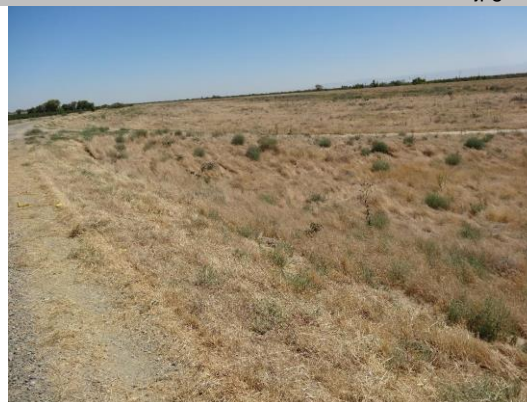
Photo 3 of 3 : UCIP\_SP\_2017\_50067\_75506.jpg

View of WS.

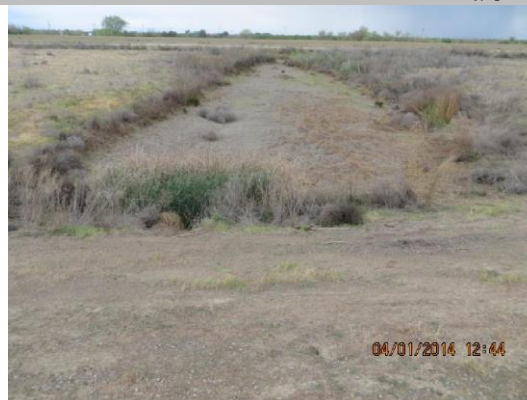
Photo 1 of 3 : UCIP\_SP\_2017\_39535\_59745.jpg

LM Start	14.69	Rating **	M	Issue No.	20
LM End	14.69	Issue Type +	Ma	Location *	LS
Category	Supplemental			GPS Latitude/Longitude	
				Start	End
Item	DWR UCIP LMA Responsibility			36.789066 °	36.789066 °
				-120.300644 °	-120.300644 °
DWR ID					
Comment Code					
Inspector Comment					
FS_ID:39535 DS_ID:19920 EP_NO: N/A Repair Type: Non-Urgent Crossing Status: Found UCIP Comments: Heavy vegetation buildup at LS toe--recommend clearing. FIELD_STRUCT_DESC: 30-inch square R.C.B.C. through the levee, 14.0 feet below the crown. Concrete "U" headwall on the waterward end. Flap gate on the waterward end. Concrete headwall on landward end. (USACE-1967). This entry matches the Drainage or Irrigation Structure referenced in O&M manual (HLM 14.69). FS Date: 4/1/2014

Concrete headwall at WS toe.

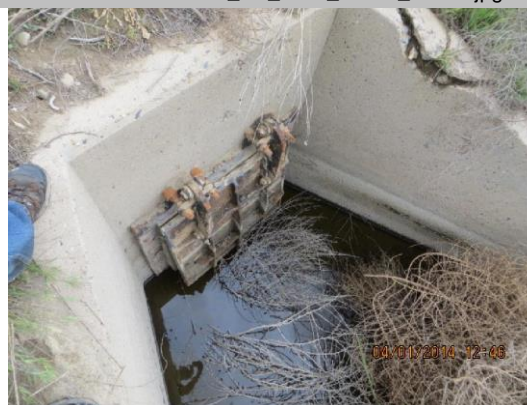
Photo 2 of 3 : UCIP\_SP\_2017\_39535\_59747.jpg

Flapgate on Concrete headwall at WS toe.

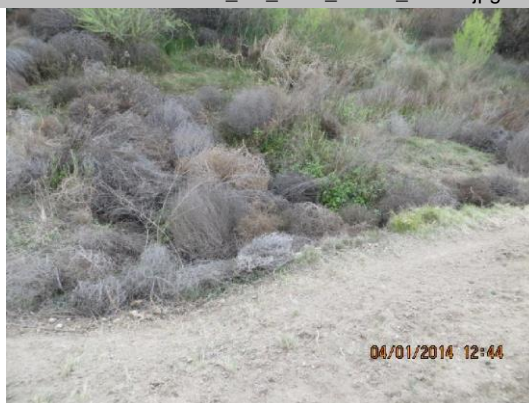
Photo 3 of 3 : UCIP\_SP\_2017\_39535\_59746.jpg

LM Start	14.69	Rating **	M	Issue No.	20 (cont)
LM End	14.69	Issue Type +	Ma	Location *	LS
Category	Supplemental			GPS Latitude/Longitude	
				Start	End
Item	DWR UCIP LMA Responsibility			36.789066 °	36.789066 °
				-120.300644 °	-120.300644 °
DWR ID					
Comment Code					
Inspector Comment					
FS_ID:39535 DS_ID:19920 EP_NO: N/A Repair Type: Non-Urgent Crossing Status: Found UCIP Comments: Heavy vegetation buildup at LS toe--recommend clearing. FIELD_STRUCT_DESC: 30-inch square R.C.B.C. through the levee, 14.0 feet below the crown. Concrete "U" headwall on the waterward end. Flap gate on the waterward end. Concrete headwall on landward end. (USACE-1967). This entry matches the Drainage or Irrigation Structure referenced in O&M manual (HLM 14.69). FS Date: 4/1/2014

Concrete headwall at channel on LS toe. Heavy vegetation buildup.

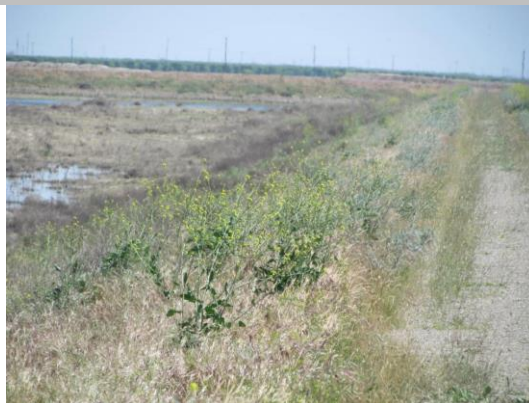
Photo 1 of 1 : SP\_2017\_NA0010\_137\_6\_20170425\_00018.jpg

LM Start	0.00	Rating **	M	Issue No.	6
LM End	15.32	Issue Type +	Ma	Location *	WS
Category	Earthen Levee			GPS Latitude/Longitude	
				Start	End
Item	Vegetation			36.974133 °	36.773888 °
				-120.363257 °	-120.285360 °
DWR ID	DWR_NA0010_18_s_2017_6				
Comment Code					
V1 : Control annual grass and weeds on the levee slopes and easements.					
Inspector Comment

Looking at typical view of waterward slope.

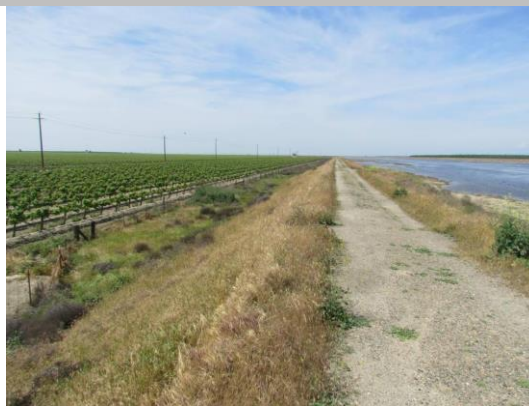
Photo 1 of 1 : SP\_2017\_NA0010\_137\_10\_20170425\_00019.jpg

LM Start	0.00	Rating **	M	Issue No.	10
LM End	13.24	Issue Type +	Ma	Location *	LS
Category	Earthen Levee			GPS Latitude/Longitude	
				Start	End
Item	Vegetation			36.974113 °	36.796253 °
				-120.363258 °	-120.308384 °
DWR ID	DWR_NA0010_18_f_2016_10				
Comment Code					
V1 : Control annual grass and weeds on the levee slopes and easements.					
Inspector Comment					
Control veg.on levee shoulder and slope.

Looking at typical view of landward slope.

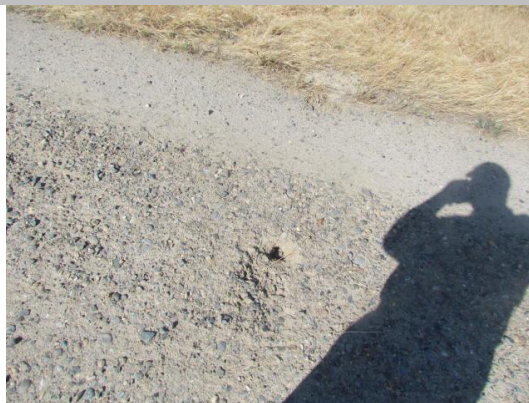
Photo 1 of 1 : SP\_2017\_NA0010\_137\_7\_20170417\_00002.jpg

LM Start	1.44	Rating **	M	Issue No.	7
LM End	1.44	Issue Type +	Ma	Location *	LS
Category	Earthen Levee			GPS Latitude/Longitude	
				Start	End
Item	Animal Control			36.956163 °	36.956163 °
				-120.353672 °	-120.353672 °
DWR ID	DWR_NA0010_18_s_2014_7				
Comment Code					
A3 : No rodents visible, but rodent burrows visible; need to backfill and compact or grout burrows.					
Inspector Comment					
Several noted on landward slope and on levee crown.

Looking at typical view of rodent holes within this section on landward slope.

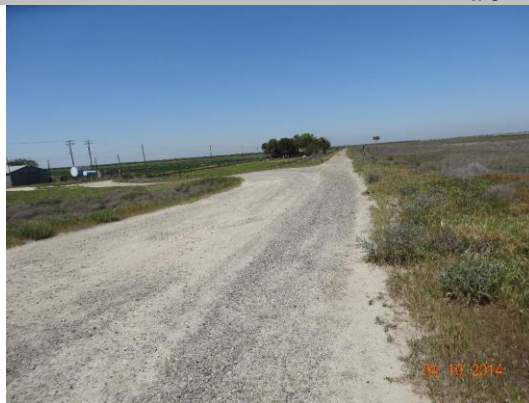
Photo 1 of 3 : UCIP\_SP\_2017\_39503\_66660.jpg

Comment Code					
Inspector Comment					
FS_ID:39503 DS_ID:19925 EP_NO: 6603 Repair Type: Non-Urgent Crossing Status: Found UCIP Comments: Need to contact owner. Appears abandoned--good candidate for video or pressure inspection. This crossings is the same age as the pipe that has failed immediately upstream. FIELD_STRUCT_DESC: 15-inch steel pipe through the levee, 4.3 feet below the crown. Electrical conduit through the levee, 4.3 feet below the crown. Siphon breaker on landward shoulder. 36-inch concrete standpipe on landward berm. Inlet facility on waterward bank consisting of pump, 42-inch concrete standpipe, and 20-inch concrete channel intake pipe with cutoff wall. (Permit No. 6603-1970) FS Date: 4/10/2014

Overview of levee crown at crossing.

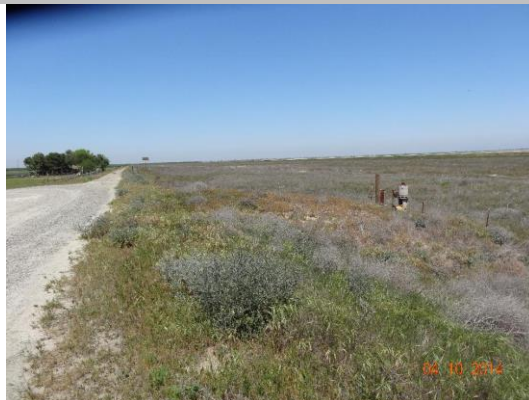
Photo 2 of 3 : UCIP\_SP\_2017\_39503\_66657.jpg

View of waterward side.

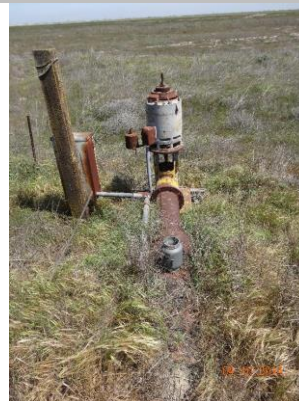
Photo 3 of 3 : UCIP\_SP\_2017\_39503\_66658.jpg

Comment Code						
Inspector Comment						
FS_ID:39503 DS_ID:19925 EP_NO: 6603 Repair Type: Non-Urgent Crossing Status: Found UCIP Comments: Need to contact owner. Appears abandoned--good candidate for video or pressure inspection. This crossings is the same age as the pipe that has failed immediately upstream. FIELD_STRUCT_DESC: 15-inch steel pipe through the levee, 4.3 feet below the crown. Electrical conduit through the levee, 4.3 feet below the crown. Siphon breaker on landward shoulder. 36-inch concrete standpipe on landward berm. Inlet facility on waterward bank consisting of pump, 42-inch concrete standpipe, and 20-inch concrete channel intake pipe with cutoff wall. (Permit No. 6603-1970) FS Date: 4/10/2014

Pump system located on waterward slope.

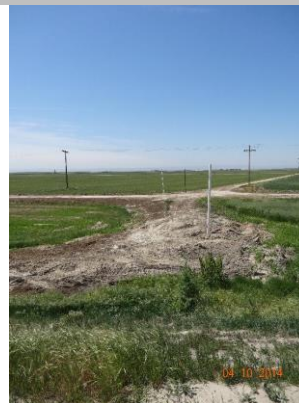
Photo 1 of 3 : UCIP\_SP\_2017\_49968\_60558.jpg

Comment Code					
Inspector Comment					
FS_ID:49968 DS_ID:19926 EP_NO: 6603 Repair Type: Non-Urgent Crossing Status: Found UCIP Comments: 7/20/2016 High burrow activity. Dense vegetation limits the inspector's visibility to identify signs of pipe failure (leaks) along the WS and LS slope. Recommend removing vegetation along pipe alignment to conduct proper inspection of structure and appurtenances. (DWR UCIP - omagana)4/10/2014 Subsidence present along pipe alignment on landward side. Modified crossing--worked done on landward side. Need to contact owner to determine permit authorizing work. Dense vegetation on landward side--tall grass. Pipe wall cut and new pipe sleeved on landward side. (DWR UCIP - omagana) FIELD_STRUCT_DESC: 15-inch steel pipe and electrical conduit through the levee, 3.7 feet below the crown. Siphon breaker located on landside (LS) shoulder. 36-inch concrete standpipe is located on the LS berm. Inlet facility located on the WS bank consisting of pump, 42-inch concrete standpipe, and 20-inch concrete channel intake pipe with cutoff wall. (Permit No. 6603, 1970 - R. Costales) [Additional Reference(s): DWR Levee Log, 2002] FS Date: 7/20/2016

Overview of LS--site modified.

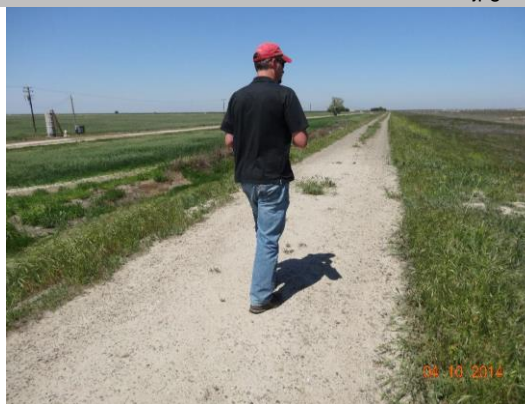
Photo 2 of 3 : UCIP\_SP\_2017\_49968\_60559.jpg

View of levee crown at crossing.

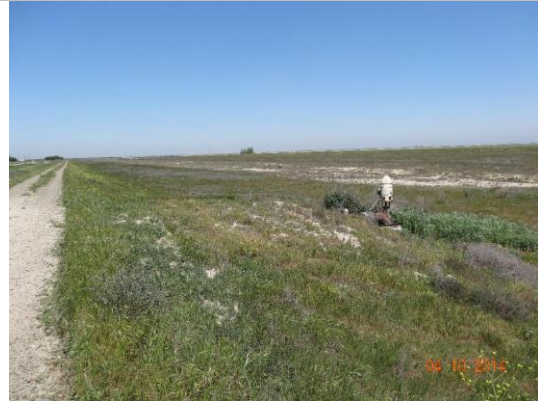
Photo 3 of 3 : UCIP\_SP\_2017\_49968\_60560.jpg

Comment Code					
Inspector Comment					
FS_ID:49968 DS_ID:19926 EP_NO: 6603 Repair Type: Non-Urgent Crossing Status: Found UCIP Comments: 7/20/2016 High burrow activity. Dense vegetation limits the inspector's visibility to identify signs of pipe failure (leaks) along the WS and LS slope. Recommend removing vegetation along pipe alignment to conduct proper inspection of structure and appurtenances. (DWR UCIP - omagana)4/10/2014 Subsidence present along pipe alignment on landward side. Modified crossing--worked done on landward side. Need to contact owner to determine permit authorizing work. Dense vegetation on landward side--tall grass. Pipe wall cut and new pipe sleeved on landward side. (DWR UCIP - omagana) FIELD_STRUCT_DESC: 15-inch steel pipe and electrical conduit through the levee, 3.7 feet below the crown. Siphon breaker located on landside (LS) shoulder. 36-inch concrete standpipe is located on the LS berm. Inlet facility located on the WS bank consisting of pump, 42-inch concrete standpipe, and 20-inch concrete channel intake pipe with cutoff wall. (Permit No. 6603, 1970 - R. Costales) [Additional Reference(s): DWR Levee Log, 2002] FS Date: 7/20/2016

View of WS.

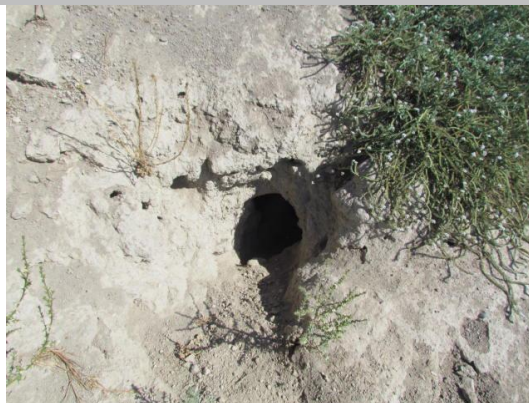
Photo 2 of 2 : SP\_2017\_NA0010\_137\_8\_20170417\_00004.jpg

LM Start	2.25	Rating **	U	Issue No.	8 (cont)	
LM End	2.25	Issue Type +	Ma	Location *	LS	
Category	Earthen Levee			GPS Latitude/Longitude		
				Start		End
Item	Animal Control			36.945563 °		36.945563 °
				-120.347121 °		-120.347121 °
DWR ID	DWR_NA0010_18_f_2015_8					
Comment Code						
A3 : No rodents visible, but rodent burrows visible; need to backfill and compact or grout burrows.						
Inspector Comment						
One large rodent hole and other rodent holes within this area.

Looking at close-up view of large rodent hole on landward slope.

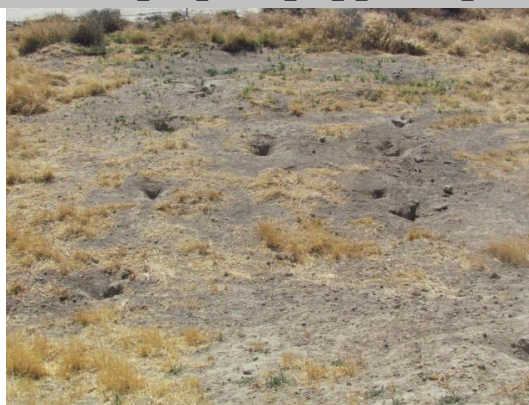
Photo 1 of 1 : SP\_2017\_NA0010\_137\_1\_20170417\_00001.jpg

LM Start	5.89	Rating **	M	Issue No.	1
LM End	5.89	Issue Type +	Ma	Location *	LS
Category	Earthen Levee			GPS Latitude/Longitude	
				Start	End
Item	Animal Control			36.895175 °	36.895175 °
				-120.327632 °	-120.327632 °
DWR ID	DWR_NA0010_18_s_2015_1				
Comment Code					
A3 : No rodents visible, but rodent burrows visible; need to backfill and compact or grout burrows.					
Inspector Comment					
Several large rodent holes noted on landward slope and berm within this section.

Looking at several rodent holes on landward slope.

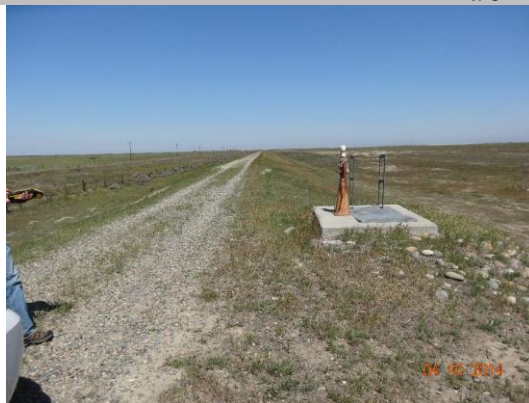
Photo 1 of 3 : UCIP\_SP\_2017\_36843\_67202.jpg

LM Start	7.54	Rating **	M	Issue No.	13
LM End	7.54	Issue Type +	En	Location *	WS
Category	Supplemental			GPS Latitude/Longitude	
				Start	End
Item	DWR UCIP Field Study			36.872431 °	36.872431 °
				-120.319415 °	-120.319415 °
DWR ID					
Comment Code					
Inspector Comment					
FS_ID:36843 DS_ID:19930 EP_NO: N/A Repair Type: Non-Urgent Crossing Status: Found UCIP Comments: CMP crossing is distorted on waterward side. Debris scattered on landward side. Sediment deposit inside crossing visible from landward side. Recommend removing debris from landward side. FIELD_STRUCT_DESC: 42-inch concrete pipe through the levee, 19.0 feet below the crown. Gate structure on waterward shoulder. Pipe section on waterward side is corrugated metal and pipe section on lanward side is reinforced concrete. (Permit No. 13548-1984, New Stone Water District) FS Date: 4/10/2014

Overview of levee crown at crossing--slide gate inside concrete box located on waterward shoulder.

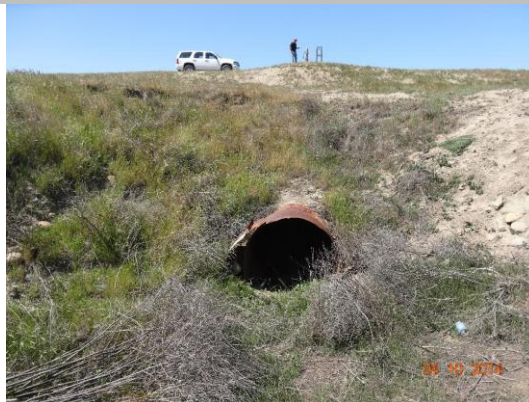
Photo 2 of 3 : UCIP\_SP\_2017\_36843\_67205.jpg

Pipe section distorted on waterward side.

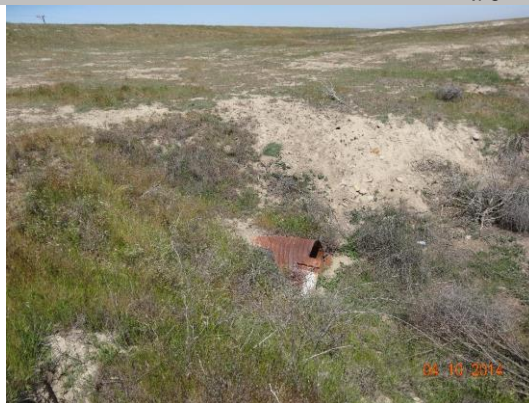
Photo 3 of 3 : UCIP\_SP\_2017\_36843\_67200.jpg

LM Start	7.54	Rating **	M	Issue No.	13 (cont)	
LM End	7.54	Issue Type +	En	Location *	WS	
Category	Supplemental			GPS Latitude/Longitude		
				Start		End
Item	DWR UCIP Field Study			36.872431 °		36.872431 °
				-120.319415 °		-120.319415 °
DWR ID						
Comment Code						
Inspector Comment						
FS_ID:36843 DS_ID:19930 EP_NO: N/A Repair Type: Non-Urgent Crossing Status: Found UCIP Comments: CMP crossing is distorted on waterward side. Debris scattered on landward side. Sediment deposit inside crossing visible from landward side. Recommend removing debris from landward side. FIELD_STRUCT_DESC: 42-inch concrete pipe through the levee, 19.0 feet below the crown. Gate structure on waterward shoulder. Pipe section on waterward side is corrugated metal and pipe section on lanward side is reinforced concrete. (Permit No. 13548-1984, New Stone Water District) FS Date: 4/10/2014

CMP section visible on waterward side.

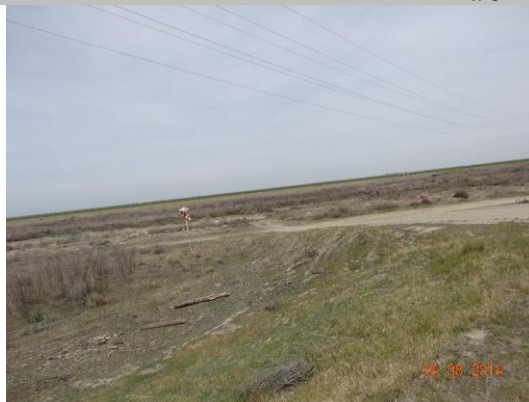
Photo 1 of 3 : UCIP\_SP\_2017\_39505\_67226.jpg

LM Start	13.59	Rating **	M	Issue No.	14
LM End	13.59	Issue Type +	En	Location *	WS
Category	Supplemental			GPS Latitude/Longitude	
				Start	End
Item	DWR UCIP Field Study			36.792684 °	36.792684 °
				-120.304542 °	-120.304542 °
DWR ID					
Comment Code					
Inspector Comment					
FS_ID:39505					
DS_ID:19932					
EP_NO: N/A					
Repair Type: Non-Urgent					
Crossing Status: Indicator Found					
UCIP Comments: Multiple markers visible along waterward and landward sides unable to confirm how many crossings go through levee. Need to contact owner to obtain additional details on crossings.					
FIELD_STRUCT_DESC: 6-inch gas line through the levee. Extends underneath the channel.					
FS Date: 4/8/2014

Markers visible on waterward side.

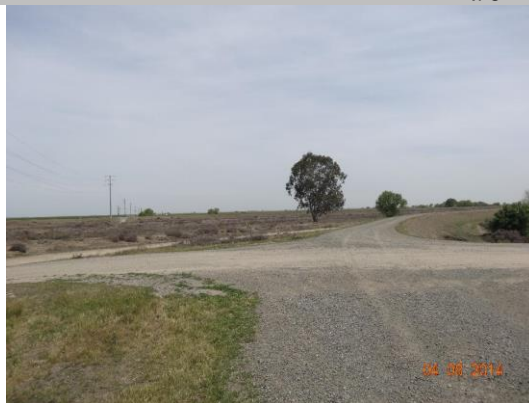
Photo 2 of 3 : UCIP\_SP\_2017\_39505\_67225.jpg

LM Start	13.59	Rating **	M	Issue No.	14 (cont)	
LM End	13.59	Issue Type +	En	Location *	WS	
Category	Supplemental			GPS Latitude/Longitude		
				Start	End	
Item	DWR UCIP Field Study			36.792684 °	36.792684 °	
				-120.304542 °	-120.304542 °	
DWR ID						
Comment Code						
Inspector Comment						
FS_ID:39505						
DS_ID:19932						
EP_NO: N/A						
Repair Type: Non-Urgent						
Crossing Status: Indicator Found						
UCIP Comments: Multiple markers visible along waterward and landward sides unable to confirm how many crossings go through levee. Need to contact owner to obtain additional details on crossings.						
FIELD_STRUCT_DESC: 6-inch gas line through the levee. Extends underneath the channel.						
FS Date: 4/8/2014

View of levee crown at crossing.

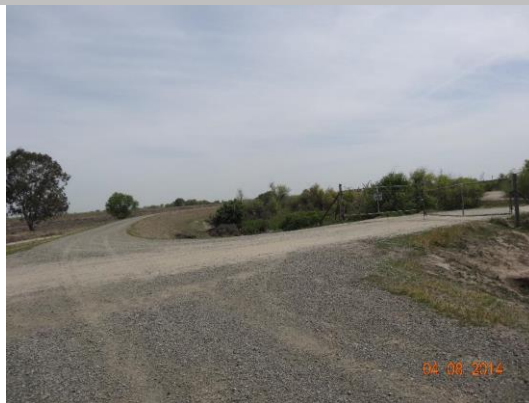
Photo 3 of 3 : UCIP\_SP\_2017\_39505\_67224.jpg

Ramp visible on landward side.

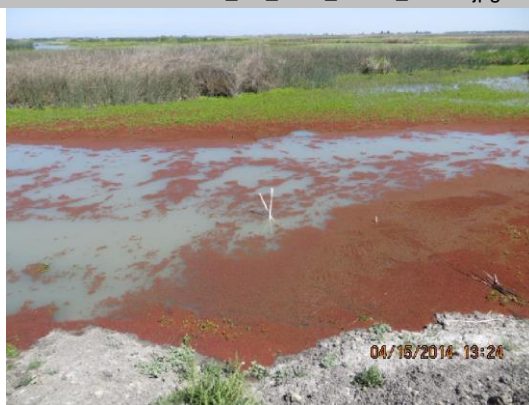
Photo 1 of 3 : UCIP\_SP\_2017\_49959\_61060.jpg

Comment Code						
Inspector Comment						
FS_ID:49959 DS_ID:19933 EP_NO: N/A Repair Type: Non-Urgent Crossing Status: Found UCIP Comments: 07/19/2016 Gate inside riser appears operable--riser lid damage. Crossing is not visible on LS due to dense vegetation. Recommend clearing dense vegetation along WS and LS slope and repairing riser cover. (DWR UCIP - omagana)04/15/2014 No actuator wheel on slide gate at WS shoulder. (DWR UCIP - omagana) FIELD_STRUCT_DESC: 24-inch corrugated metal drainage pipe through the levee, 14.8 feet below the crown. Slide gate inside 36-inch corrugated metal pipe (CMP) riser located on the the waterside (WS) slope. Concrete "U" headwalls on both WS and landside (LS) ends. [Additional Reference(s): DWR Levee Log, 2002. USACE San Joaquin O&M Manuals: Unit No. 601, 1967, (HLM 0.10), Unit No. 601 Part I, 1967 (Amended in 1978), Unit No. 601 Part II, 1969, and Unit No. 601 Part III, 1969]. FS Date: 7/19/2016

PVC pipes sticking up out of channel likely indicate pipe location on WS toe.

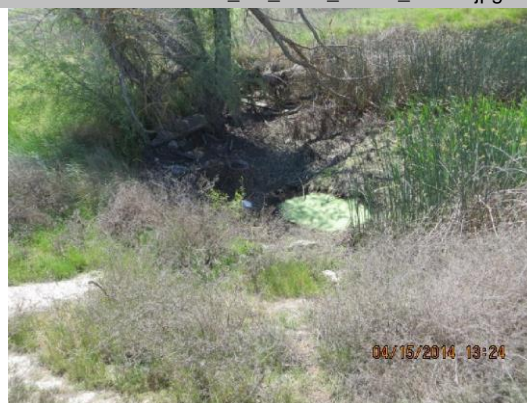
Photo 2 of 3 : UCIP\_SP\_2017\_49959\_61061.jpg

Item	DWR UCIP LMA Responsibility			37.207039 °	37.207039 °	
				-120.696255 °	-120.696255 °	
DWR ID						
Comment Code						
Inspector Comment						
FS_ID:49959 DS_ID:19933 EP_NO: N/A Repair Type: Non-Urgent Crossing Status: Found UCIP Comments: 07/19/2016 Gate inside riser appears operable--riser lid damage. Crossing is not visible on LS due to dense vegetation. Recommend clearing dense vegetation along WS and LS slope and repairing riser cover. (DWR UCIP - omagana)04/15/2014 No actuator wheel on slide gate at WS shoulder. (DWR UCIP - omagana) FIELD_STRUCT_DESC: 24-inch corrugated metal drainage pipe through the levee, 14.8 feet below the crown. Slide gate inside 36-inch corrugated metal pipe (CMP) riser located on the the waterside (WS) slope. Concrete "U" headwalls on both WS and landside (LS) ends. [Additional Reference(s): DWR Levee Log, 2002. USACE San Joaquin O&M Manuals: Unit No. 601, 1967, (HLM 0.10), Unit No. 601 Part I, 1967 (Amended in 1978), Unit No. 601 Part II, 1969, and Unit No. 601 Part III, 1969]. FS Date: 7/19/2016

Concrete headwall at toe of LS slope.

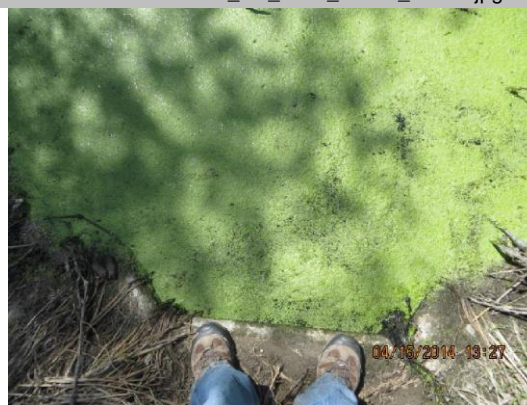
Photo 3 of 3 : UCIP\_SP\_2017\_49959\_61059.jpg

Concrete headwall at LS toe.

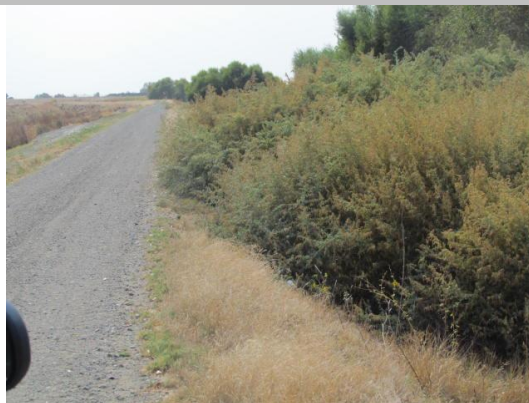
Photo 1 of 2 : SP\_2017\_NA0010\_138\_21\_20170417\_00012.jpg

LM Start	0.53	Rating **	U	Issue No.	21
LM End	0.85	Issue Type +	Ma	Location *	LS
Category	Earthen Levee			GPS Latitude/Longitude	
				Start	End
Item	Vegetation			37.213006 °	37.217593 °
				-120.698019 °	-120.697400 °
DWR ID	DWR_NA0010_22A_f _ 2014_21				
Comment Code					
V2 : Remove the wild growth other than native grasses from the levee slopes.					
Inspector Comment					
Dense vegetation on landward slope.

Looking at dense vegetation on landward slope. Fall 2015

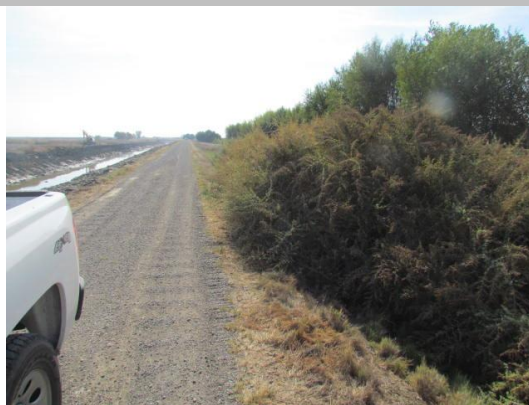
Photo 2 of 2 : SP\_2017\_NA0010\_138\_21\_20170417\_00013.jpg

Looking south at dense vegetation on landward slope. Spring 2015

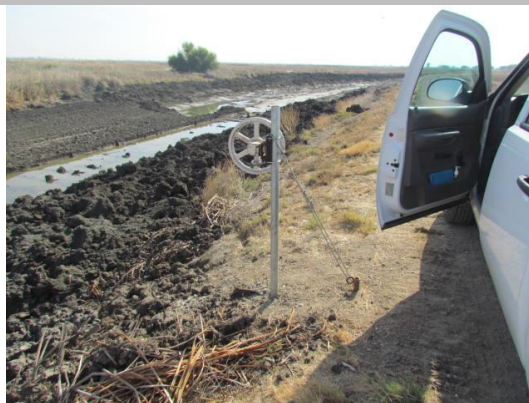
Photo 1 of 1 : SP\_2017\_NA0010\_138\_23\_20170417\_00014.jpg

LM Start	0.87	Rating **	M	Issue No.	23
LM End	0.87	Issue Type +	En	Location *	WS
Category	Earthen Levee			GPS Latitude/Longitude	
				Start	End
Item	Encroachments			37.217802 °	37.217802 °
				-120.697416 °	-120.697416 °
DWR ID	DWR_NA0010_22A_f_2014_23				
Comment Code					
SI : Sign					
Inspector Comment					
Pulley on waterward shouder without board permit.

Looking south at pulley on waterward shoulder.

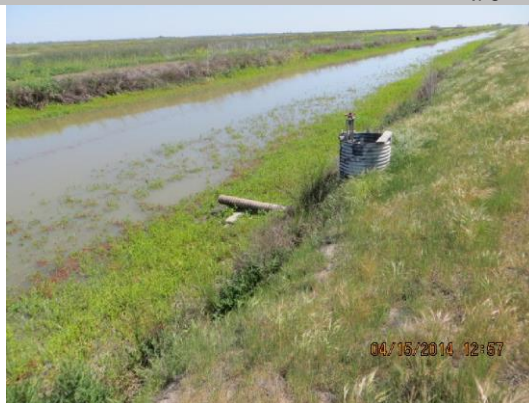
Photo 1 of 3 : UCIP\_SP\_2017\_33733\_61030.jpg

LM Start	1.57	Rating **	M	Issue No.	261
LM End	1.57	Issue Type +	En	Location *	WS
Category	Supplemental			GPS Latitude/Longitude	
				Start	End
Item	DWR UCIP Field Study			37.227588 °	37.227588 °
				-120.700945 °	-120.700945 °
DWR ID					
Comment Code					
Inspector Comment					
FS_ID:33733 DS_ID:19936 EP_NO: N/A Repair Type: Non-Urgent Crossing Status: Found UCIP Comments: Slide gate rusted and does not function. Headwall buried at LS toe. Pipe appears abandoned and if so should be done so properly. FIELD_STRUCT_DESC: 8-inch CM irrigation pipe through levee, 7.0-feet below the crown. Slide gate inside 36-inch CM pipe riser in the waterward slope. Concrete headwall on the landward end. (USACE-1967). This entry matches the Drainage or Irrigation Structure referenced in O&M manual (HLM 1.57). FS Date: 4/15/2014

Pipe and CMP riser with slide gate visible on WS slope.

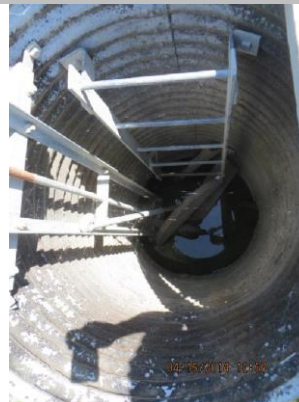
Photo 2 of 3 : UCIP\_SP\_2017\_33733\_61029.jpg

Inside CMP riser on WS shoulder.

LM Start	1.57	Rating **	M	Issue No.	261 (cont)	
LM End	1.57	Issue Type +	En	Location *	WS	
Category	Supplemental			GPS Latitude/Longitude		
				Start		End
Item	DWR UCIP Field Study			37.227588 °		37.227588 °
				-120.700945 °		-120.700945 °
DWR ID						
Comment Code						
Inspector Comment						
FS_ID:33733 DS_ID:19936 EP_NO: N/A Repair Type: Non-Urgent Crossing Status: Found UCIP Comments: Slide gate rusted and does not function. Headwall buried at LS toe. Pipe appears abandoned and if so should be done so properly. FIELD_STRUCT_DESC: 8-inch CM irrigation pipe through levee, 7.0-feet below the crown. Slide gate inside 36-inch CM pipe riser in the waterward slope. Concrete headwall on the landward end. (USACE-1967). This entry matches the Drainage or Irrigation Structure referenced in O&M manual (HLM 1.57). FS Date: 4/15/2014

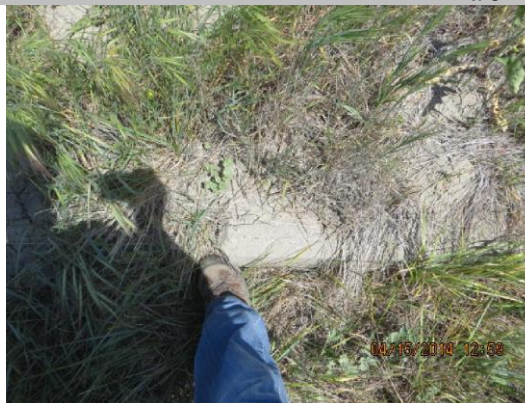
Photo 3 of 3 : UCIP\_SP\_2017\_33733\_61028.jpg

Buried concrete headwall on LS toe.

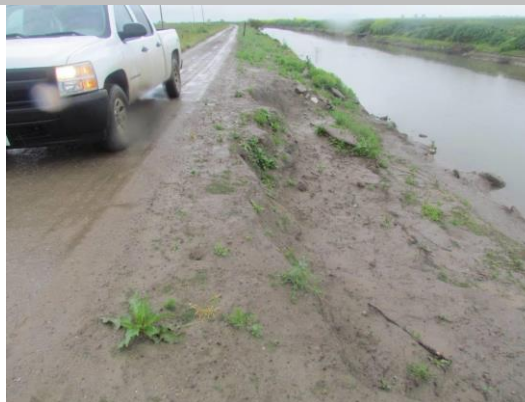
Photo 1 of 1 : SP\_2017\_NA0010\_138\_7\_20170425\_00028.jpg

LM Start	2.65	Rating **	U	Issue No.	7
LM End	2.65	Issue Type +	Ma	Location *	WS
Category	Earthen Levee			GPS Latitude/Longitude	
				Start	End
Item	Erosion / Bank Caving			37.242595 °	37.242595 °
				-120.706470 °	-120.706470 °
DWR ID	DWR_NA0010_22A_s_2017_7				
Comment Code					
E2 : Schedule repair of erosion site prior to the next inspection.					
Inspector Comment					
Erosion cutting into waterward shoulder.

Looking downstream at erosion on waterward shoulder and slope.

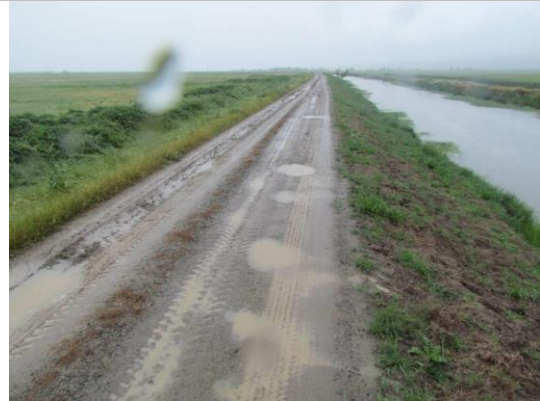
Photo 1 of 1 : SP\_2017\_NA0010\_138\_10\_20170425\_00029.jpg

LM Start	2.65	Rating **	U	Issue No.	10
LM End	5.09	Issue Type +	Ma	Location *	CR
Category	Earthen Levee			GPS Latitude/Longitude	
				Start	End
Item	Crown Surface / Depressions / Rutting			37.242595 °	37.267962 °
				-120.706470 °	-120.736909 °
DWR ID	DWR_NA0010_22A_s_2012_10				
Comment Code					
C2 : Repair depressions or ruts in the crown or slope.					
Inspector Comment					
Several pot holes and depression along levee crown.

Looking downstream at rutting and potholes on levee crown.

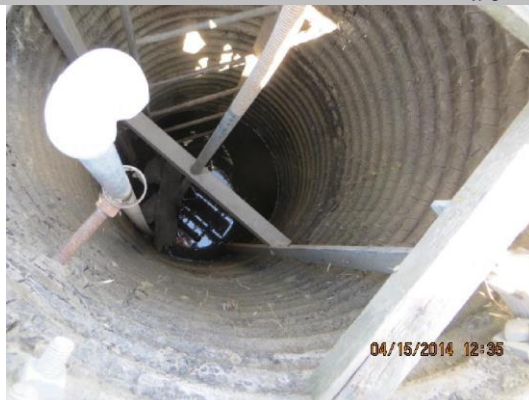
Photo 2 of 3 : UCIP\_SP\_2017\_33732\_61024.jpg

LM Start	2.71	Rating **	M	Issue No.	262 (cont)	
LM End	2.71	Issue Type +	En	Location *	CR	
Category	Supplemental			GPS Latitude/Longitude		
				Start		End
Item	DWR UCIP Field Study			37.243501 °		37.243501 °
				-120.706773 °		-120.706773 °
DWR ID						
Comment Code						
Inspector Comment						
FS_ID:33732						
DS_ID:19937						
EP_NO: N/A						
Repair Type: Non-Urgent						
Crossing Status: Found						
UCIP Comments: Slide gate does not function and should be repaired.						
Headwall at LS toe not found.						
FIELD_STRUCT_DESC: 24-inch CM irrigation pipe through the levee,						
7.5-feet below the crown. Slide gate inside 36-inch CM pipe riser in the						
waterward slope. Concrete "U" headwall on the landward end. (USACE-						
1967). This entry matches the Drainage or Irrigation Structure						
referenced in O&M manual (HLM 2.72).						
FS Date: 4/15/2014

Inside CMP riser on WS shoulder.

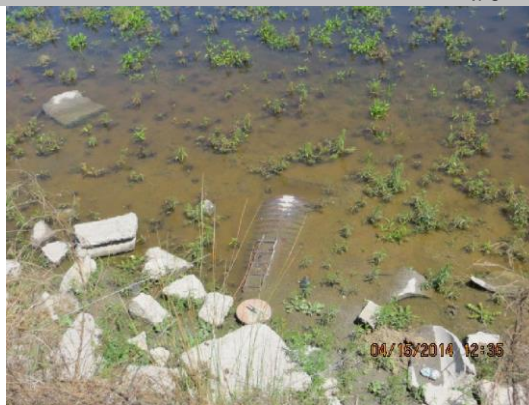
Photo 3 of 3 : UCIP\_SP\_2017\_33732\_61025.jpg

Pipe visible on WS toe.

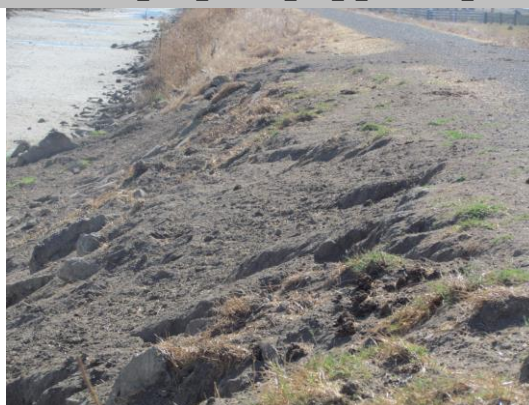
Photo 1 of 1 : SP\_2017\_NA0010\_138\_9\_20170417\_00007.jpg

LM Start	3.64	Rating **	U	Issue No.	9
LM End	3.69	Issue Type +	Ma	Location *	WS
Category	Earthen Levee			GPS Latitude/Longitude	
				Start	End
Item	Erosion / Bank Caving			37.253362 °	37.253862 °
				-120.717873 °	-120.718507 °
DWR ID	DWR_NA0010_22A_f_2016_9				
Comment Code					
E1 : Note and monitor erosion site.					
Inspector Comment					
Erosion or Levee damage caused by animal traffic.

Looking downstream at animal erosion on waterward slope.

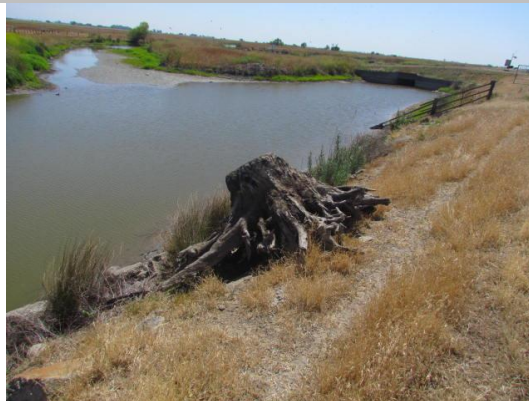
Photo 1 of 1 : SP\_2017\_NA0010\_138\_259\_20170417\_00015.jpg

LM Start	3.80	Rating **	M	Issue No.	259	
LM End	3.80	Issue Type +	Ma	Location *	WS	
Category	Earthen Levee			GPS Latitude/Longitude		
				Start		End
Item	Encroachments			37.255067 °		37.255067 °
				-120.719910 °		-120.719910 °
DWR ID	DWR_NA0010_22A_s_2015_259					
Comment Code						
TR : Tree or limb						
Inspector Comment						
Dead tree stump on waterward slope.

Looking east at dead stump on waterward slope.

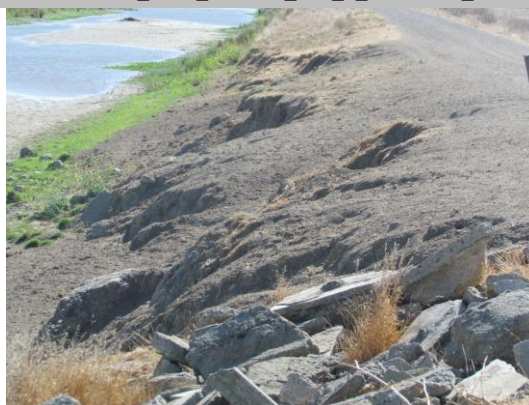
Photo 1 of 2 : SP\_2017\_NA0010\_138\_8\_20170417\_00005.jpg

LM Start	4.87	Rating **	U	Issue No.	8
LM End	4.87	Issue Type +	Ma	Location *	WS
Category	Earthen Levee			GPS Latitude/Longitude	
				Start	End
Item	Slope Stability			37.265813 °	37.265813 °
				-120.733748 °	-120.733748 °
DWR ID	DWR_NA0010_22A_f_2016_8				
Comment Code					
S1 : Repair slope instability.					
Inspector Comment					
Levee damage caused by animal traffic.

Looking downstream at animal erosion on waterward slope.

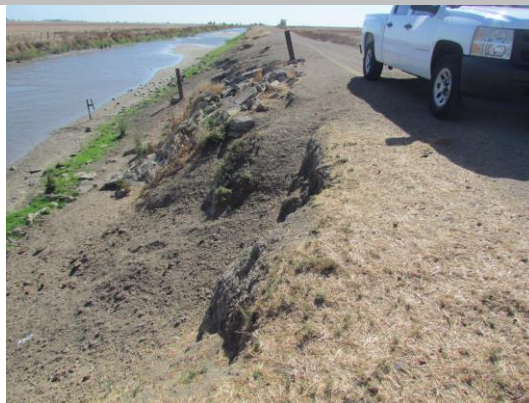
Photo 2 of 2 : SP\_2017\_NA0010\_138\_8\_20170417\_00006.jpg

Looking downstream at animal erosion on waterward slope.

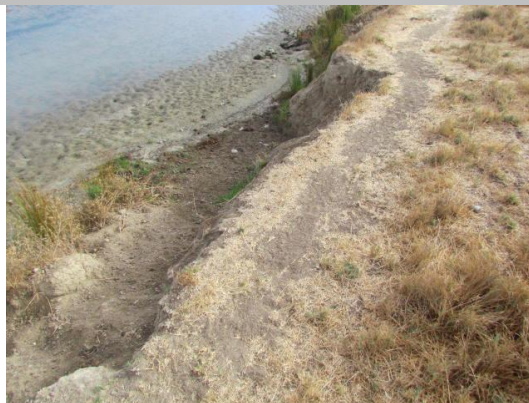
Photo 1 of 2 : SP\_2017\_NA0010\_138\_4\_20170417\_00001.jpg

LM Start	5.05	Rating **	M	Issue No.	4
LM End	5.05	Issue Type +	Ma	Location *	WS
Category	Earthen Levee			GPS Latitude/Longitude	
				Start	End
Item	Erosion / Bank Caving			37.267516 °	37.267516 °
				-120.736401 °	-120.736401 °
DWR ID	DWR_NA0010_22A_f _ 2013_4				
Comment Code					
E2 : Schedule repair of erosion site prior to the next inspection.					
Inspector Comment					
Erosion caused by animal traffic.

Looking southeast at livestock erosion on waterward toe.

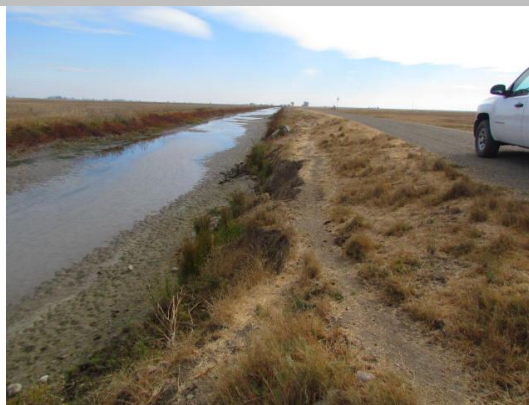
Photo 2 of 2 : SP\_2017\_NA0010\_138\_4\_20170417\_00002.jpg

Looking southeast at livestock erosion on waterward toe.

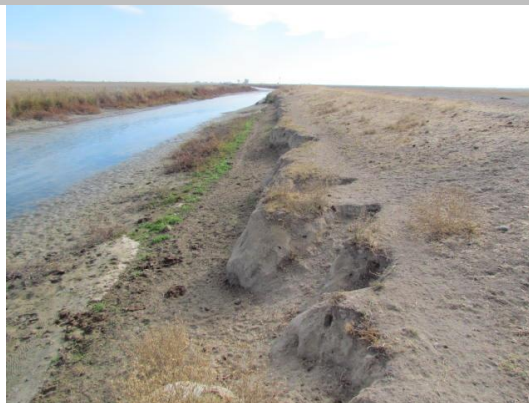
Photo 1 of 2 : SP\_2017\_NA0010\_138\_6\_20170417\_00003.jpg

LM Start	5.14	Rating **	M	Issue No.	6
LM End	5.20	Issue Type +	Ma	Location *	WS
Category	Earthen Levee			GPS Latitude/Longitude	
				Start	End
Item	Animal Control			37.268492 °	37.269133 °
				-120.737493 °	-120.738208 °
DWR ID	DWR_NA0010_22A_s_2012_6				
Comment Code					
A2 : Repair the levee slope damaged by livestock and prevent large animal access.					
Inspector Comment					
Slope damage caused by livestock on waterside toe.

Looking southeast at livestock erosion on waterward toe.

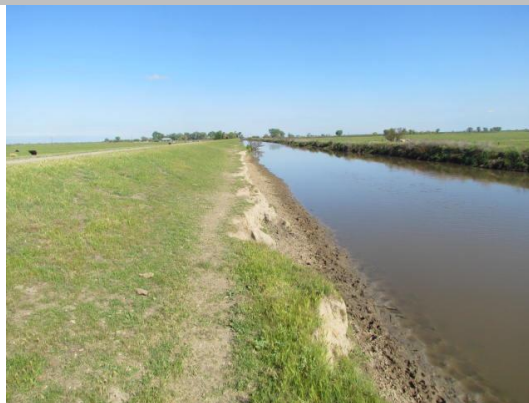
Photo 2 of 2 : SP\_2017\_NA0010\_138\_6\_20170417\_00004.jpg

LM Start	5.14	Rating **	M	Issue No.	6 (cont)	
LM End	5.20	Issue Type +	Ma	Location *	WS	
Category	Earthen Levee			GPS Latitude/Longitude		
				Start		End
Item	Animal Control			37.268492 °		37.269133 °
				-120.737493 °		-120.738208 °
DWR ID	DWR_NA0010_22A_s_2012_6					
Comment Code						
A2 : Repair the levee slope damaged by livestock and prevent large animal access.						
Inspector Comment						
Slope damage caused by livestock on waterside toe.

Looking northwest at livestock erosion along waterside slope and toe.

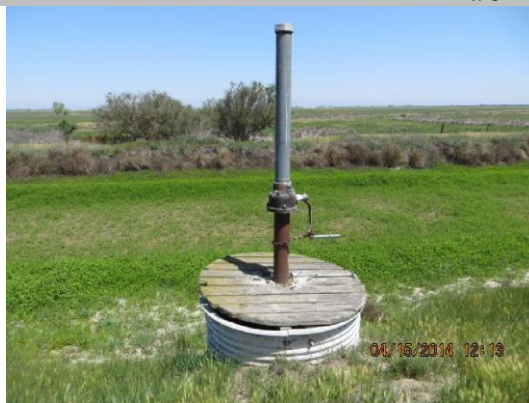
Photo 1 of 3 : UCIP\_SP\_2017\_39536\_61022.jpg

LM Start	5.48	Rating **	M	Issue No.	263
LM End	5.48	Issue Type +	En	Location *	WS
Category	Supplemental			GPS Latitude/Longitude	
				Start	End
Item	DWR UCIP Field Study			37.272079 °	37.272079 °
				-120.741575 °	-120.741575 °
DWR ID					
Comment Code					
Inspector Comment					
FS_ID:39536 DS_ID:19938 EP_NO: N/A Repair Type: Non-Urgent Crossing Status: Found UCIP Comments: Need to contact owner. Pipe silted in on LS toe. Appears abandoned and if so should be done so properly. FIELD_STRUCT_DESC: 48-inch CM irrigation pipe through the levee, 10 feet below the crown. Slide gate inside 60-inch CM pipe riser in the waterward slope. Concrete headwall on the landward end. Waterward end capped with 1/4-inch steel plate. (USACE-1967). This entry matches the Drainage or Irrigation Structure referenced in O&M manual (HLM 5.48). FS Date: 4/15/2014

Slidegate inside riser on WS shoulder.

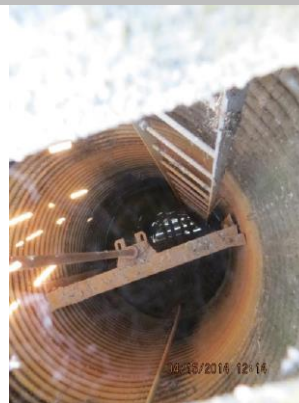
Photo 2 of 3 : UCIP\_SP\_2017\_39536\_61021.jpg

Item	DWR UCIP Field Study			37.272079 °	37.272079 °	
				-120.741575 °	-120.741575 °	
DWR ID						
Comment Code						
Inspector Comment						
FS_ID:39536						
DS_ID:19938						
EP_NO: N/A						
Repair Type: Non-Urgent						
Crossing Status: Found						
UCIP Comments: Need to contact owner. Pipe silted in on LS toe.						
Appears abandoned and if so should be done so properly.						
FIELD_STRUCT_DESC: 48-inch CM irrigation pipe through the levee,						
10 feet below the crown. Slide gate inside 60-inch CM pipe riser in the						
waterward slope. Concrete headwall on the landward end. Waterward						
end capped with 1/4-inch steel plate. (USACE-1967). This entry						
matches the Drainage or Irrigation Structure referenced in O&M manual						
(HLM 5.48).						
FS Date: 4/15/2014

Inside riser on WS shoulder.

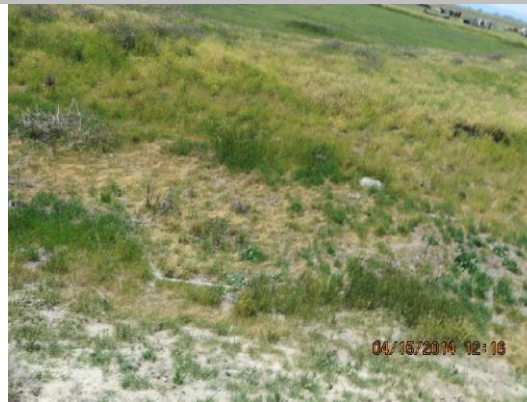
Photo 3 of 3 : UCIP\_SP\_2017\_39536\_61020.jpg

Buried headwall on LS toe.

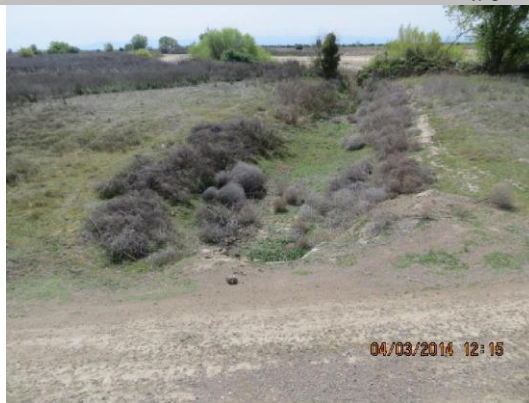
Photo 1 of 3 : UCIP\_SP\_2017\_39537\_59860.jpg

LM Start	0.21	Rating **	M	Issue No.	30
LM End	0.21	Issue Type +	Ma	Location *	WS
Category	Supplemental			GPS Latitude/Longitude	
				Start	End
Item	DWR UCIP LMA Responsibility			36.772713 °	36.772713 °
				-120.280670 °	-120.280670 °
DWR ID					
Comment Code					
Inspector Comment					
FS_ID:39537 DS_ID:19945 EP_NO: N/A Repair Type: Non-Urgent Crossing Status: Found UCIP Comments: Excessive vegetation at inlet--recommend clearing. FIELD_STRUCT_DESC: 30-inch square R.C.B.C. through the levee 13.0 feet below the crown. Concrete "U" headwall on the waterward end. Flap gate on the waterward end. Concrete headwall on the landward end. (USACE-1967). This entry matches the Drainage or Irrigation Structure referenced in O&M manual (HLM 0.21). Cleaned and rehabilitated under Permit No. 13085 (1981). FS Date: 4/3/2014

Concrete headwall on WS toe at channel.

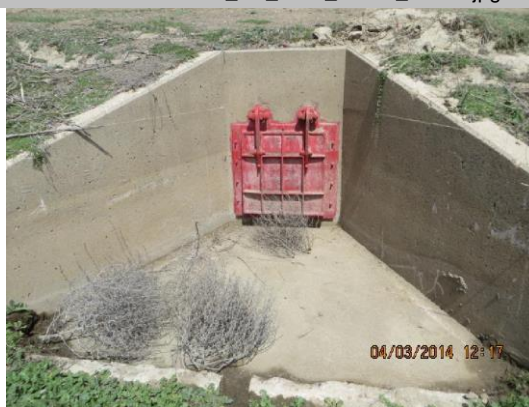
Photo 2 of 3 : UCIP\_SP\_2017\_39537\_59859.jpg

Flapgate on Concrete headwall at WS toe.

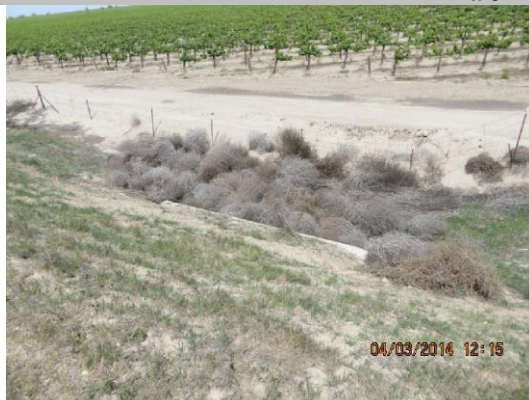
Photo 3 of 3 : UCIP\_SP\_2017\_39537\_59861.jpg

LM Start	0.21	Rating **	M	Issue No.	30 (cont)
LM End	0.21	Issue Type +	Ma	Location *	WS
Category	Supplemental			GPS Latitude/Longitude	
				Start	End
Item	DWR UCIP LMA Responsibility			36.772713 °	36.772713 °
				-120.280670 °	-120.280670 °
DWR ID					
Comment Code					
Inspector Comment					
FS_ID:39537 DS_ID:19945 EP_NO: N/A Repair Type: Non-Urgent Crossing Status: Found UCIP Comments: Excessive vegetation at inlet--recommend clearing. FIELD_STRUCT_DESC: 30-inch square R.C.B.C. through the levee 13.0 feet below the crown. Concrete "U" headwall on the waterward end. Flap gate on the waterward end. Concrete headwall on the landward end. (USACE-1967). This entry matches the Drainage or Irrigation Structure referenced in O&M manual (HLM 0.21). Cleaned and rehabilitated under Permit No. 13085 (1981). FS Date: 4/3/2014

Concrete headwall at LS toe. Excess vegetation buildup at inlet.
