**Flood Control Project Maintenance  
Levee Inspections**  
**LMA District Cover Sheet**  
**Spring 2017 Levee Inspection Results**

**Lower San Joaquin Levee District**

Waterway			Bank	Unit Miles
Unit No. 01 San Joaquin River			Right	22.52
	Spring (March - May)	Summer (June - August)	(September - November) Fall	Winter (December - February)
Unit Maintenance Rating (Fall Only)				
Date of Inspection	4/17/2017 - 4/20/2017			
DWR Inspector	Richard Willoughby			
Accompanied By

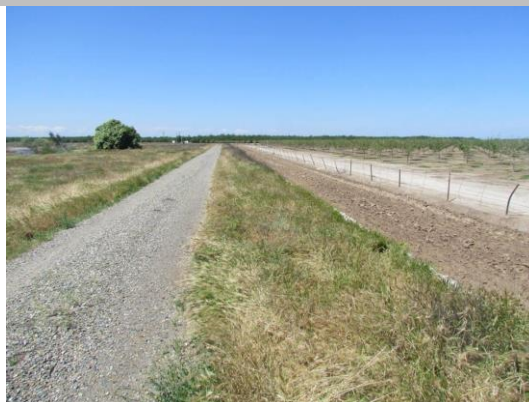
Photo 1 of 1 : SP\_2017\_NA0010\_139\_20\_20170425\_00056.jpg

LM Start	0.42	Rating **	M	Issue No.	20
LM End	9.50	Issue Type +	Ma	Location *	LS
Category	Earthen Levee			GPS Latitude/Longitude	
				Start	End
Item	Vegetation			36.772445 °	36.804327 °
				-120.277082 °	-120.169140 °
DWR ID	DWR_NA0010_23_f_2016_20				
Comment Code					
V1 : Control annual grass and weeds on the levee slopes and easements.					
Inspector Comment

Looking at typical view of landward slope.

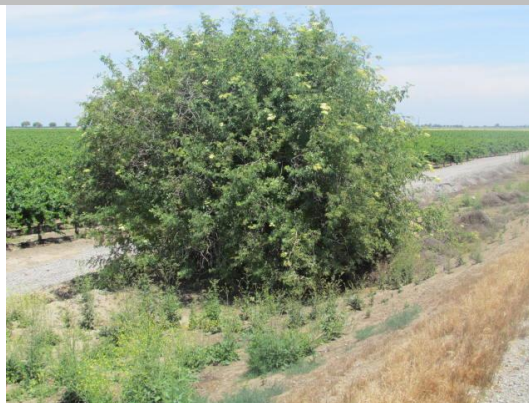
Photo 1 of 1 : SP\_2017\_NA0010\_139\_6\_20170417\_00007.jpg

LM Start	1.21	Rating **	M	Issue No.	6
LM End	1.21	Issue Type +	Ma	Location *	LS
Category	Earthen Levee			GPS Latitude/Longitude	
				Start	End
Item	Vegetation			36.772973 °	36.772973 °
				-120.264768 °	-120.264768 °
DWR ID	DWR_NA0010_23_s_2013_6				
Comment Code					
V4 : Elderberries are blocking visibility and flood fight capability.					
Inspector Comment					
Control growth of elderberry on landward toe.

Looking at elderberry on landward toe.

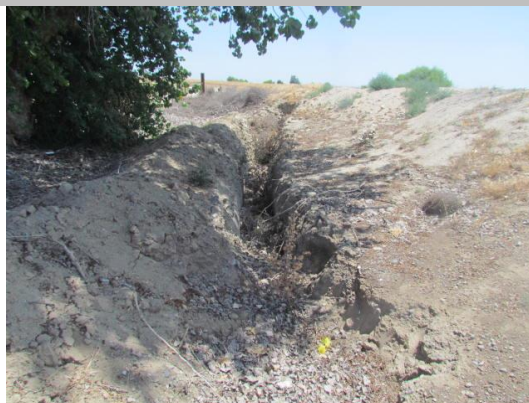
Photo 1 of 3 : SP\_2017\_NA0010\_139\_29\_20170417\_00026.jpg

LM Start	1.53	Rating **	U	Issue No.	29
LM End	1.53	Issue Type +	En	Location *	LS
Category	Earthen Levee			GPS Latitude/Longitude	
				Start	End
Item	Encroachments			36.772041 °	36.772041 °
				-120.259549 °	-120.259549 °
DWR ID	DWR_NA0010_23_f_2014_29				
Comment Code					
DT : Ditch					
Inspector Comment					
Trench at landward toe. Trench is ten to twelve inches wide and twenty feet long.

Looking southeast at trench at landward toe. (Spring 2015)

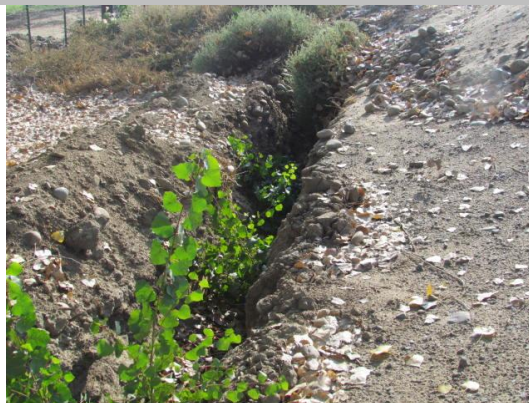
Photo 2 of 3 : SP\_2017\_NA0010\_139\_29\_20170417\_00027.jpg

Looking southeast at trench at landward toe.

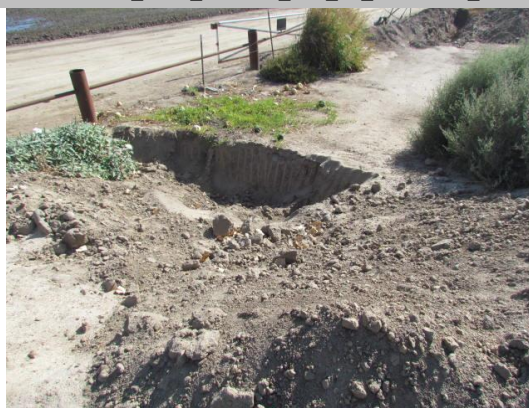
Photo 1 of 3 : SP\_2017\_NA0010\_139\_24\_20170417\_00022.jpg

LM Start	1.54	Rating **	U	Issue No.	24
LM End	1.54	Issue Type +	En	Location *	LS
Category	Earthen Levee			GPS Latitude/Longitude	
				Start	End
Item	Encroachments			36.771922 °	36.771922 °
				-120.259321 °	-120.259321 °
DWR ID	DWR_NA0010_23_f_2015_24				
Comment Code					
DT : Ditch					
Inspector Comment					
Landowner digging at landward berm.

Looking east at large pot hole on landward berm.

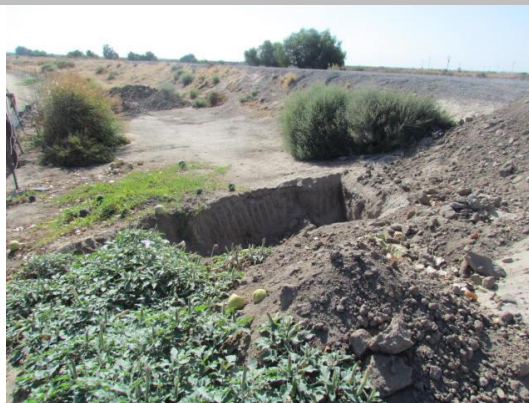
Photo 2 of 3 : SP\_2017\_NA0010\_139\_24\_20170417\_00023.jpg

Looking southeast at large pot hole on landward berm.

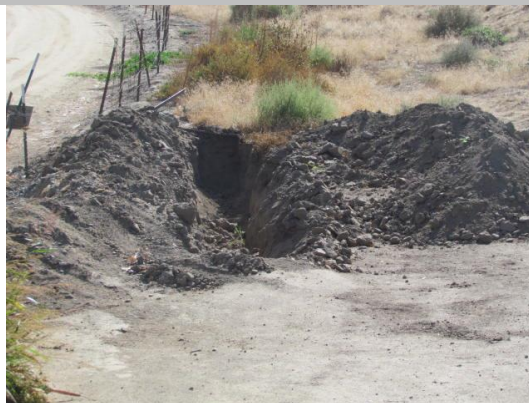
Photo 3 of 3 : SP\_2017\_NA0010\_139\_24\_20170417\_00024.jpg

LM Start	1.54	Rating **	U	Issue No.	24 (cont)	
LM End	1.54	Issue Type +	En	Location *	LS	
Category	Earthen Levee			GPS Latitude/Longitude		
				Start		End
Item	Encroachments			36.771922 °		36.771922 °
				-120.259321 °		-120.259321 °
DWR ID	DWR_NA0010_23_f_2015_24					
Comment Code						
DT : Ditch						
Inspector Comment						
Landowner digging at landward berm.

Looking southeast at trench on landward berm.

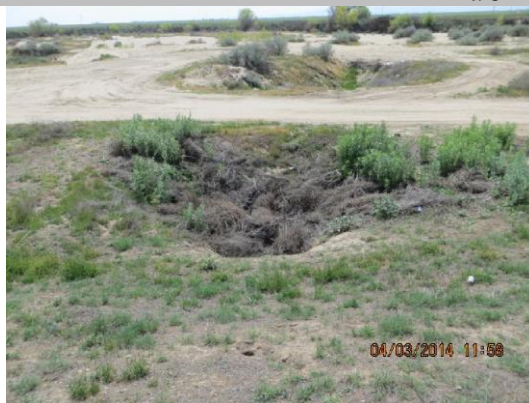
Photo 1 of 3 : UCIP\_SP\_2017\_39538\_59855.jpg

LM Start	1.63	Rating **	M	Issue No.	31
LM End	1.63	Issue Type +	En	Location *	LS
Category	Supplemental			GPS Latitude/Longitude	
				Start	End
Item	DWR UCIP Field Study			36.771408 °	36.771408 °
				-120.257899 °	-120.257899 °
DWR ID					
Comment Code					
Inspector Comment					
FS_ID:39538 DS_ID:19948 EP_NO: N/A Repair Type: Non-Urgent Crossing Status: Found UCIP Comments: Appears abandoned and if so should be done properly. Discharge channel is blocked by sand and soil making drain ineffective. Soil buildup at inlet on LS toe. Need to contact owner. FIELD_STRUCT_DESC: 30-inch square R.C.B.C. through the levee, 11.0 feet below the crown. Concrete "U" headwall on the waterward end. Flap gate on the waterward end. Concrete headwall on the landward end. FS Date: 4/3/2014

Concrete headwall on WS toe.

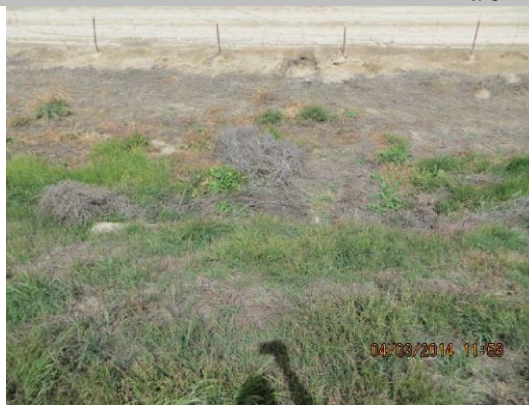
Photo 3 of 3 : UCIP\_SP\_2017\_39538\_59856.jpg

Concrete headwall on LS toe.

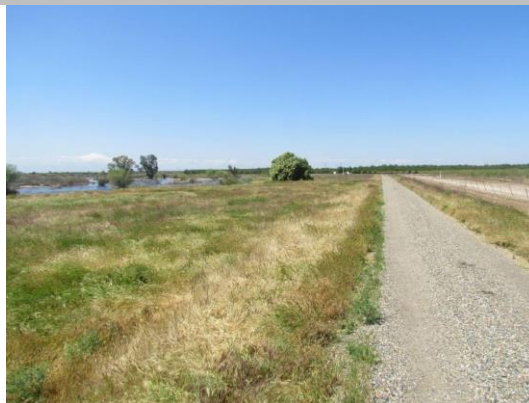
Photo 1 of 1 : SP\_2017\_NA0010\_139\_21\_20170425\_00057.jpg

LM Start	1.64	Rating **	M	Issue No.	21
LM End	9.50	Issue Type +	Ma	Location *	WS
Category	Earthen Levee			GPS Latitude/Longitude	
				Start	End
Item	Vegetation			36.771398 °	36.804327 °
				-120.257659 °	-120.169140 °
DWR ID	DWR_NA0010_23_f_2016_21				
Comment Code					
V1 : Control annual grass and weeds on the levee slopes and easements.					
Inspector Comment					
Control vegetation on levee slope.

Looking at typical view of waterward slope.

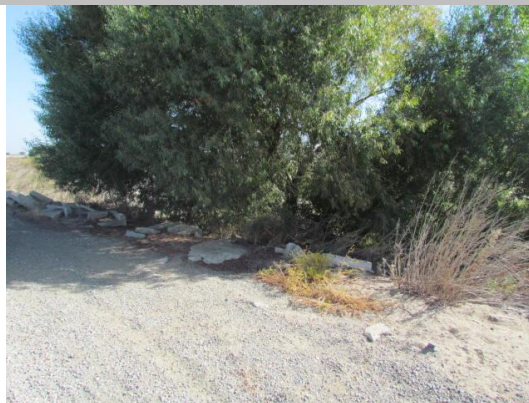
Photo 1 of 1 : SP\_2017\_NA0010\_139\_1\_20170417\_00001.jpg

LM Start	1.91	Rating **	U	Issue No.	1
LM End	1.91	Issue Type +	Ma	Location *	WS
Category	Earthen Levee			GPS Latitude/Longitude	
				Start	End
Item	Trim / Thin Trees			36.772943 °	36.772943 °
				-120.253511 °	-120.253511 °
DWR ID	DWR_NA0010_23_s_2015_1				
Comment Code					
T1 : Trim trees to at least five feet above ground level.					
Inspector Comment					
Untrimmed tree on waterward slope

Looking at untrimmed tree on waterward slope.

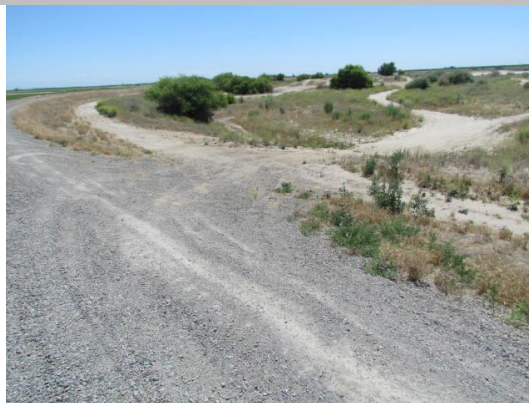
Photo 1 of 1 : SP\_2017\_NA0010\_139\_16\_20170417\_00017.jpg

LM Start	2.12	Rating **	M	Issue No.	16
LM End	2.42	Issue Type +	Ma	Location *	WS
Category	Earthen Levee			GPS Latitude/Longitude	
				Start	End
Item	Slope Stability			36.775507 °	36.774423 °
				-120.251672 °	-120.246993 °
DWR ID	DWR_NA0010_23_s_2013_16				
Comment Code					
S3 : Repair the levee slope damaged by vehicle traffic and prevent access where possible.					
Inspector Comment					
Several damaged sites within this reach. Damage caused by vehicle traffic. At. LM. 2.12, 2.21, 2.37, & 2.41

Looking west at one of several slope damaged cause by vehicle traffic.

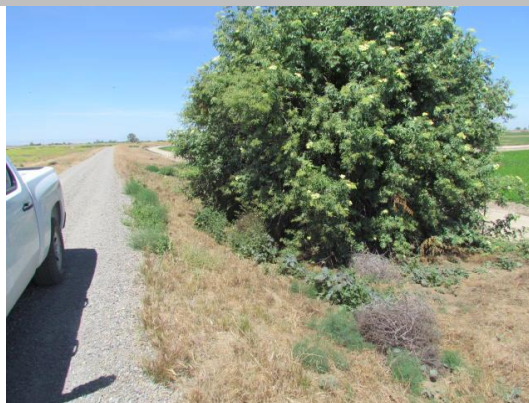
Photo 1 of 3 : SP\_2017\_NA0010\_139\_15\_20170417\_00014.jpg

LM Start	2.85	Rating **	U	Issue No.	15
LM End	2.85	Issue Type +	Ma	Location *	LS
Category	Earthen Levee			GPS Latitude/Longitude	
				Start	End
Item	Vegetation			36.771537 °	36.771537 °
				-120.240917 °	-120.240917 °
DWR ID	DWR_NA0010_23_s_2012_15				
Comment Code					
V4 : Elderberries are blocking visibility and flood fight capability.					
Inspector Comment					
Control growth of elderberry bush on landward toe.

Looking west at elderberry at landward toe. (Spring 2016)

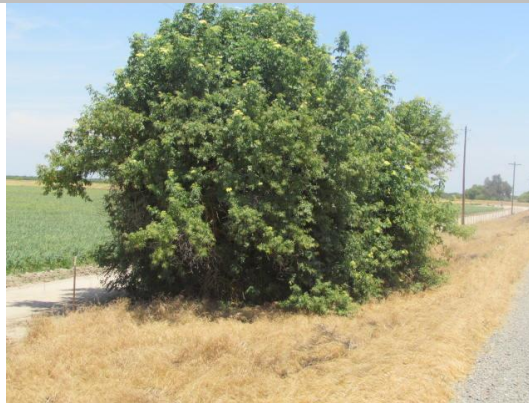
Photo 2 of 3 : SP\_2017\_NA0010\_139\_15\_20170417\_00015.jpg

Looking east at elderberry at landward toe. (Spring 2015)

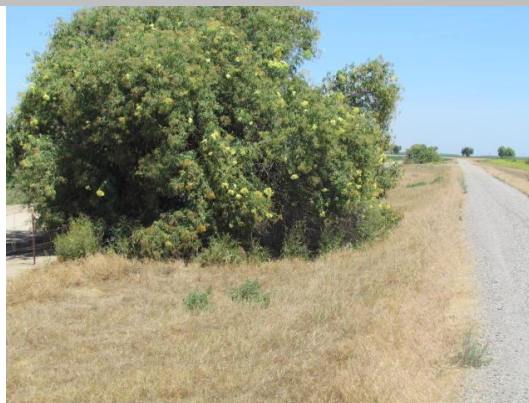
Photo 1 of 4 : SP\_2017\_NA0010\_139\_3\_20170417\_00002.jpg

LM Start	3.30	Rating **	U	Issue No.	3
LM End	3.30	Issue Type +	Ma	Location *	LS
Category	Earthen Levee			GPS Latitude/Longitude	
				Start	End
Item	Vegetation			36.774403 °	36.774403 °
				-120.234705 °	-120.234705 °
DWR ID	DWR_NA0010_23_s_2012_3				
Comment Code					
V4 : Elderberries are blocking visibility and flood fight capability.					
Inspector Comment					
Control growth of elderberry on landward toe.

Looking North at elderberry on landward toe and berm. (Spring 2016)

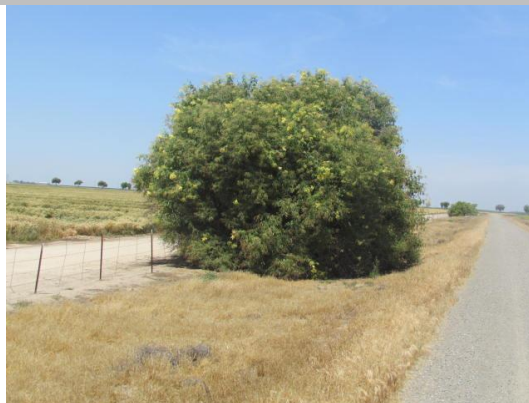
Photo 2 of 4 : SP\_2017\_NA0010\_139\_3\_20170417\_00003.jpg

Looking north at elderberry on landward toe and berm. (Spring 2015)

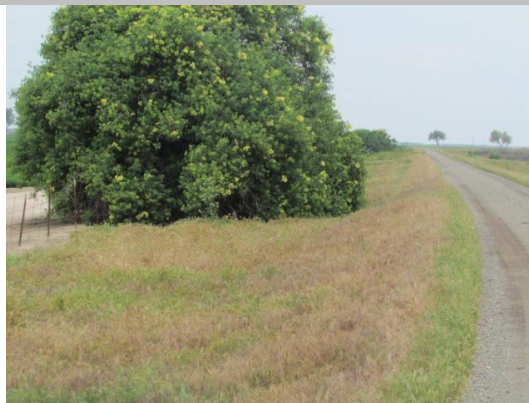
Photo 3 of 4 : SP\_2017\_NA0010\_139\_3\_20170417\_00004.jpg

Looking north at elderberry on landside toe and berm. (Fall 2014)

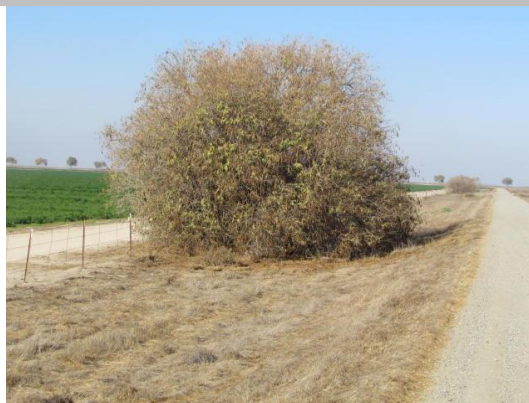
Photo 4 of 4 : SP\_2017\_NA0010\_139\_3\_20170417\_00005.jpg

Looking north at elderberry bush on landward toe. (Spring 2013)

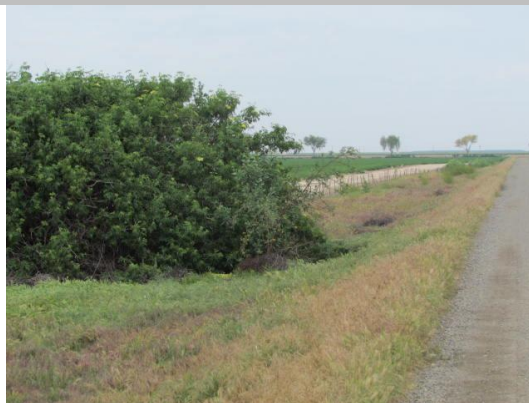
Photo 1 of 1 : SP\_2017\_NA0010\_139\_9\_20170417\_00008.jpg

LM Start	3.45	Rating **	M	Issue No.	9
LM End	3.45	Issue Type +	Ma	Location *	LS
Category	Earthen Levee			GPS Latitude/Longitude	
				Start	End
Item	Vegetation			36.776537 °	36.776537 °
				-120.234573 °	-120.234573 °
DWR ID	DWR_NA0010_23_s_2012_9				
Comment Code					
V4 : Elderberries are blocking visibility and flood fight capability.					
Inspector Comment					
Control growth of elderberry on landward toe and berm.

Looking north at elderberry on landside toe and berm.

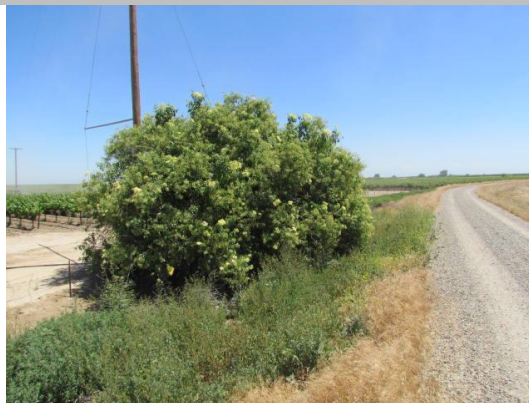
Photo 1 of 3 : SP\_2017\_NA0010\_139\_10\_20170417\_00009.jpg

Looking east at elderberry bush on landward toe. (Spring 2016)

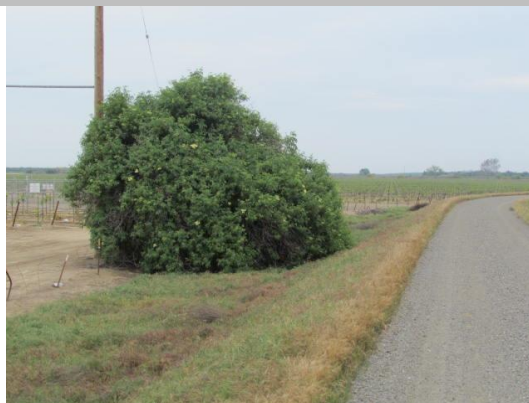
Photo 2 of 3 : SP\_2017\_NA0010\_139\_10\_20170417\_00010.jpg

Looking east at elderberry on landside toe and berm. (Spring 2015)

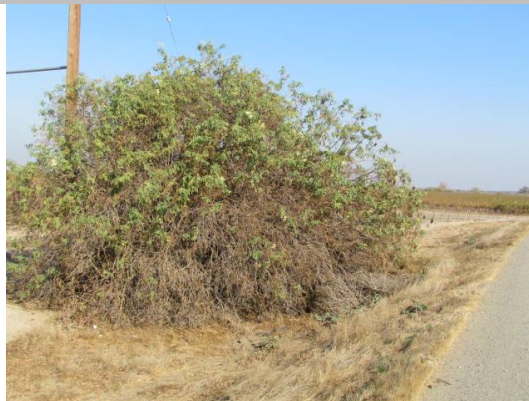
Photo 3 of 3 : SP\_2017\_NA0010\_139\_10\_20170417\_00011.jpg

Looking east at elderberry bush on landward toe. (Fall 2013)

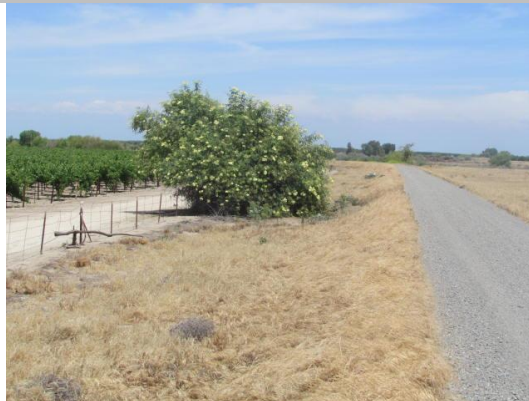
Photo 1 of 2 : SP\_2017\_NA0010\_139\_11\_20170417\_00012.jpg

LM Start	4.45	Rating **	M	Issue No.	11
LM End	4.45	Issue Type +	Ma	Location *	LS
Category	Earthen Levee			GPS Latitude/Longitude	
				Start	End
Item	Vegetation			36.784523 °	36.784523 °
				-120.223292 °	-120.223292 °
DWR ID	DWR_NA0010_23_s_2012_11				
Comment Code					
V4 : Elderberries are blocking visibility and flood fight capability.					
Inspector Comment					
Control growth of elderberry on landward toe and berm.

Looking northeast at elderberry on landward toe and berm. (Spring 2015)

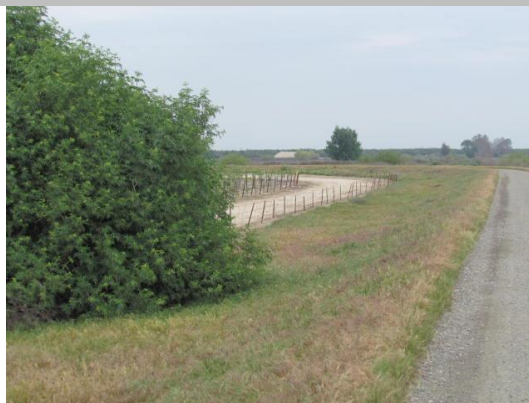
Photo 2 of 2 : SP\_2017\_NA0010\_139\_11\_20170417\_00013.jpg

Looking northeast at elderberry on landside toe and berm.

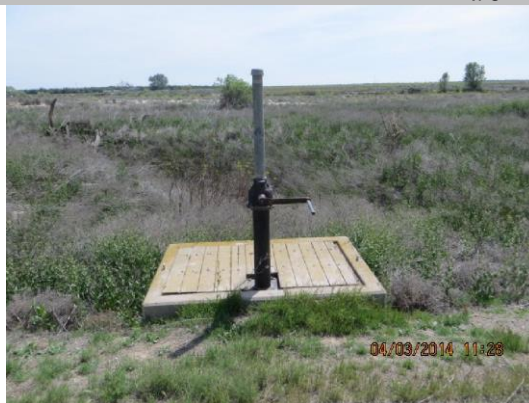
Photo 1 of 3 : UCIP\_SP\_2017\_39540\_59848.jpg

LM Start	4.85	Rating **	M	Issue No.	33
LM End	4.85	Issue Type +	En	Location *	LS
Category	Supplemental			GPS Latitude/Longitude	
				Start	End
Item	DWR UCIP Field Study			36.789550 °	36.789550 °
				-120.220367 °	-120.220367 °
DWR ID					
Comment Code					
Inspector Comment					
FS_ID:39540 DS_ID:19953 EP_NO: N/A Repair Type: Non-Urgent Crossing Status: Found UCIP Comments: Heavy vegetation at inlet and outlet--recommend clearing. FIELD_STRUCT_DESC: 30-inch square R.C.B.C. through the levee, 10.7 feet below the crown. Concrete "U" headwall on both ends. 4.5'X7' Concrete riser with slide gate on the waterward slope. Inlet channel cobble revetted 15.0 feet long. FS Date: 4/3/2014

Slide gate in concrete riser on WS shoulder.

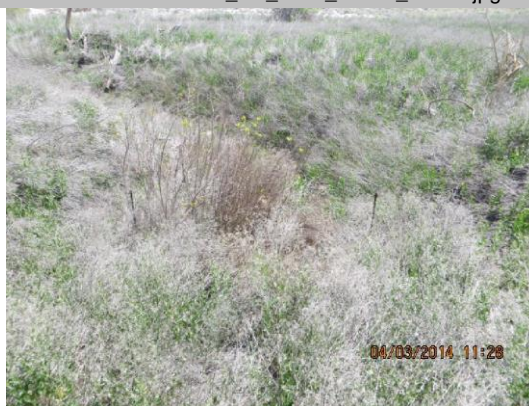
Photo 2 of 3 : UCIP\_SP\_2017\_39540\_59847.jpg

LM Start	4.85	Rating **	M	Issue No.	33 (cont)
LM End	4.85	Issue Type +	En	Location *	LS
Category	Supplemental			GPS Latitude/Longitude	
				Start	End
Item	DWR UCIP Field Study			36.789550 °	36.789550 °
				-120.220367 °	-120.220367 °
DWR ID					
Comment Code					
Inspector Comment					
FS_ID:39540 DS_ID:19953 EP_NO: N/A Repair Type: Non-Urgent Crossing Status: Found UCIP Comments: Heavy vegetation at inlet and outlet--recommend clearing. FIELD_STRUCT_DESC: 30-inch square R.C.B.C. through the levee, 10.7 feet below the crown. Concrete "U" headwall on both ends. 4.5'X7' Concrete riser with slide gate on the waterward slope. Inlet channel cobble revetted 15.0 feet long. FS Date: 4/3/2014

Heavy vegetation in outlet/channel on WS toe.

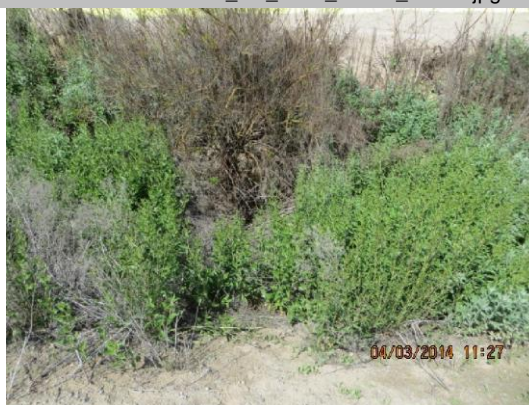
Heavy vegetation at concrete inlet on LS toe.

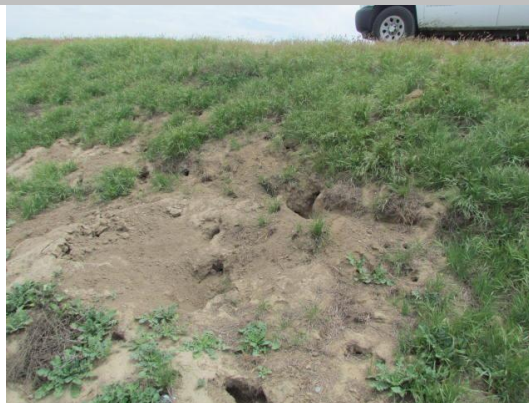
Photo 1 of 1 : SP\_2017\_NA0010\_139\_5\_20170417\_00006.jpg

LM Start	5.68	Rating **	U	Issue No.	5
LM End	5.68	Issue Type +	Ma	Location *	WS
Category	Earthen Levee			GPS Latitude/Longitude	
				Start	End
Item	Animal Control			36.791981 °	36.791981 °
				-120.206274 °	-120.206274 °
DWR ID	DWR_NA0010_23_s_2012_5				
Comment Code					
A1 : Exterminate rodents and backfill and compact or grout burrows.					
Inspector Comment					
Several large rodent holes in this area.

Looking at several rodent holes on landside slope.

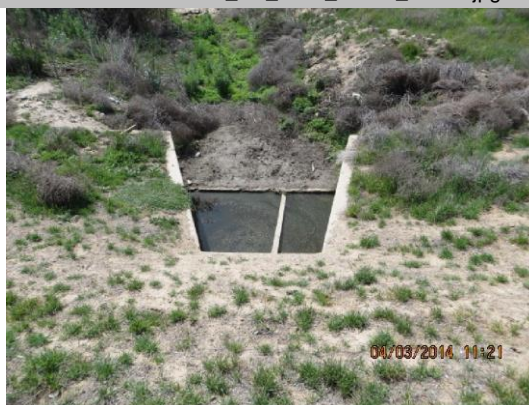
Photo 1 of 3 : UCIP\_SP\_2017\_39542\_59830.jpg

Comment Code					
Inspector Comment					
FS_ID:39542 DS_ID:19954 EP_NO: N/A Repair Type: Non-Urgent Crossing Status: Found UCIP Comments: Dense vegetation limits the inspector's visibility to identify signs of pipe failure (leaks) along the landward slope. Recommend removing vegetation along pipe alignment to conduct proper inspection of structure. FIELD_STRUCT_DESC: 36-inch square R.C.B.C through the levee 9.0 feet below the crown. Concrete "U" headwalls on both ends. Flap gate on the waterward end. Outlet channel cobble revetted 5.0 feet long. (USACE-1967). This entry matches the Drainage or Irrigation Structure referenced in O&M manual (HLM 5.71). FS Date: 4/3/2014

Concrete headwall on WS toe.

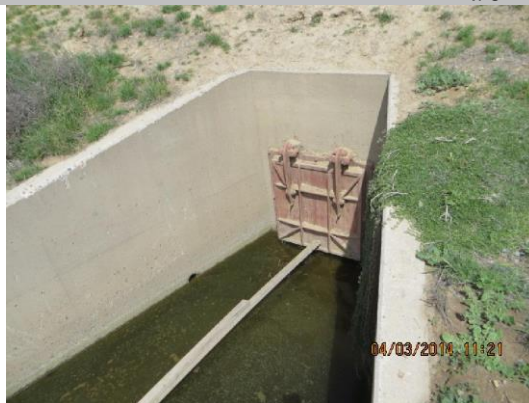
Photo 2 of 3 : UCIP\_SP\_2017\_39542\_59829.jpg

Flapgate on Concrete headwall on WS toe.

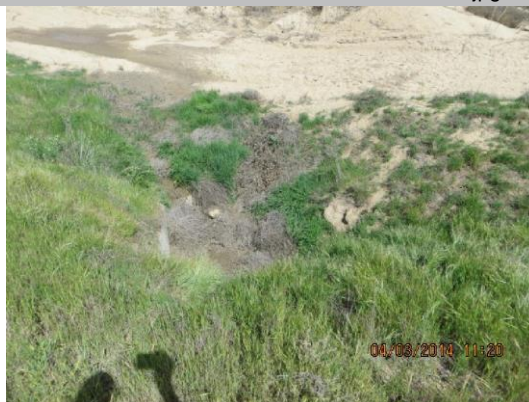
Photo 3 of 3 : UCIP\_SP\_2017\_39542\_59831.jpg

Concrete headwall at LS toe.

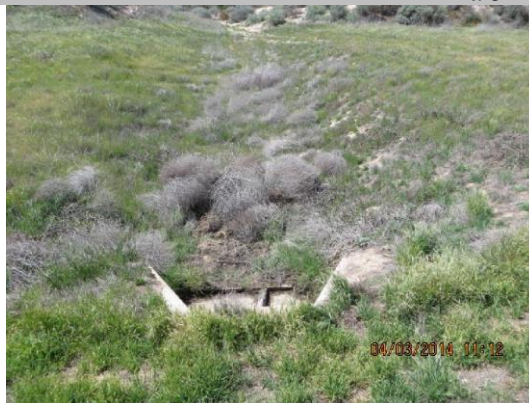
Photo 1 of 3 : UCIP\_SP\_2017\_39543\_59826.jpg

LM Start	7.06	Rating **	M	Issue No.	35
LM End	7.06	Issue Type +	En	Location *	WS
Category	Supplemental			GPS Latitude/Longitude	
				Start	End
Item	DWR UCIP Field Study			36.778783 °	36.778783 °
				-120.192447 °	-120.192447 °
DWR ID					
Comment Code					
Inspector Comment					
FS_ID:39543 DS_ID:19939 EP_NO: N/A Repair Type: Non-Urgent Crossing Status: Found UCIP Comments: Dense vegetation limits the inspector's visibility to identify signs of pipe failure (leaks) along the landward slope. Recommend removing vegetation along pipe alignment to conduct proper inspection of structure. FIELD_STRUCT_DESC: 30-inch square R.C.B.C. through the levee 8.5 feet below the crown. Concrete "U" headwall on the waterward end. Flap gate on the waterward end. Concrete headwall on the landward end. FS Date: 4/3/2014

Concrete headwall on WS toe.

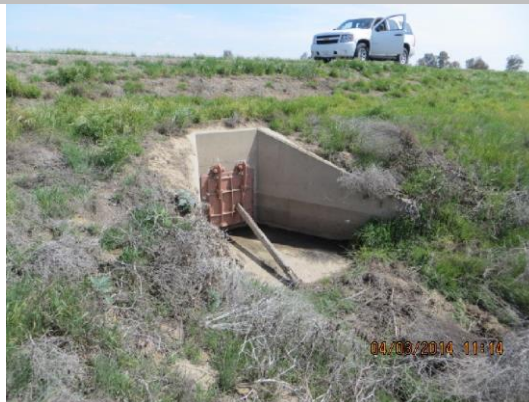
Photo 2 of 3 : UCIP\_SP\_2017\_39543\_59828.jpg

Flapgate on Concrete headwall at WS toe.

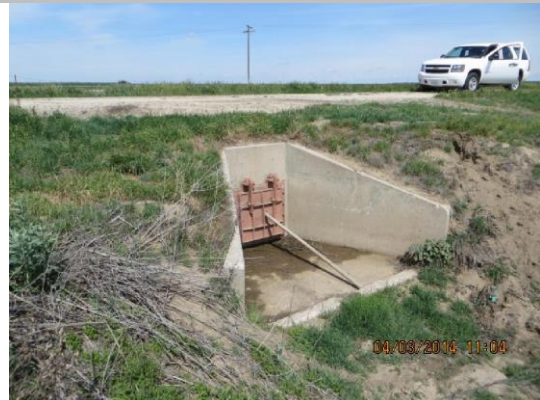
Photo 1 of 3 : UCIP\_SP\_2017\_39544\_59823.jpg

Comment Code					
Inspector Comment					
FS_ID:39544 DS_ID:19940 EP_NO: N/A Repair Type: Non-Urgent Crossing Status: Found UCIP Comments: Some sediment buildup at inlet at LS toe. Also dense vegetation limits the inspector's visibility to identify signs of pipe failure (leaks) along the landward slope. Recommend removing vegetation along pipe alignment to conduct proper inspection of structure. FIELD_STRUCT_DESC: 30-inch square R.C.B.C. through the levee, 5.2 feet below the crown. Concrete "U" headwall on the waterward end. Flap gate on the waterward end. Concrete headwalls on the landward end. (USACE-1967). This entry matches the Drainage or Irrigation Structure referenced in O&M manual (HLM 8.33). FS Date: 4/3/2014

Flapgate on WS toe.

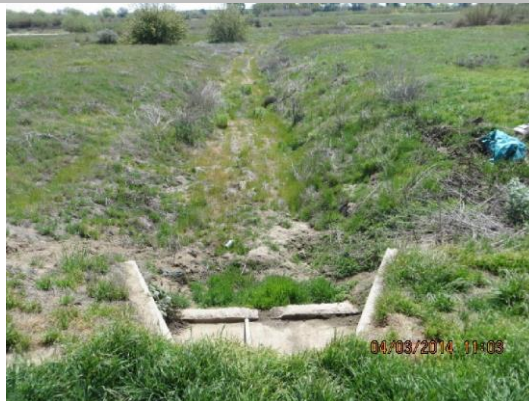
Photo 2 of 3 : UCIP\_SP\_2017\_39544\_59821.jpg

concrete headwall at drainage ditch on WS toe.

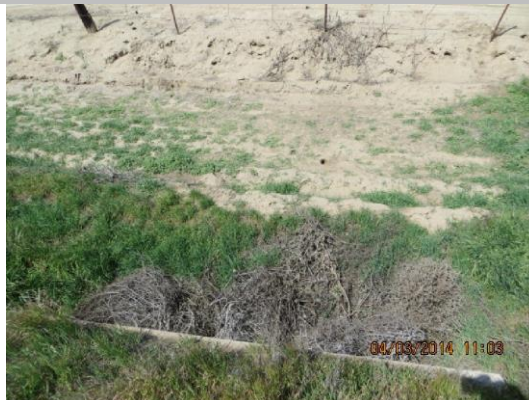
Photo 3 of 3 : UCIP\_SP\_2017\_39544\_59822.jpg

Concrete headwall on LS toe.

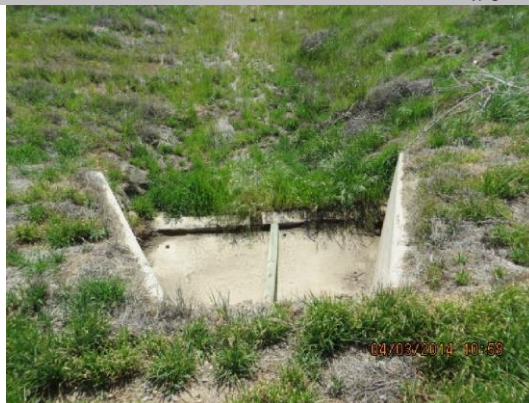
Photo 1 of 3 : UCIP\_SP\_2017\_39545\_59817.jpg

Comment Code					
Inspector Comment					
FS_ID:39545 DS_ID:19941 EP_NO: N/A Repair Type: Non-Urgent Crossing Status: Found UCIP Comments: Dense vegetation limits the inspector's visibility to identify signs of pipe failure (leaks) along the landward slope. Recommend removing vegetation along pipe alignment to conduct proper inspection of structure. FIELD_STRUCT_DESC: 30-inch square R.C.B.C. through the levee, 5.6 feet below the crown. Concrete "U" headwall on the waterward end. Flap gate on the waterward end. Concrete headwall on the landward end. (USACE-1967). This entry matches the Drainage or Irrigation Structure referenced in O&M manual (HLM 8.54). FS Date: 4/3/2014

Concrete headwall on WS toe.

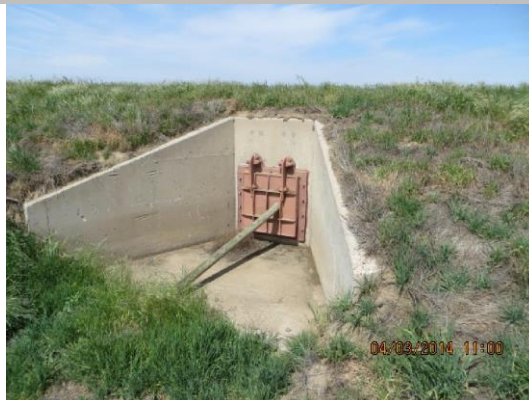
Photo 2 of 3 : UCIP\_SP\_2017\_39545\_59819.jpg

Flapgate on Concrete headwall at WS toe.

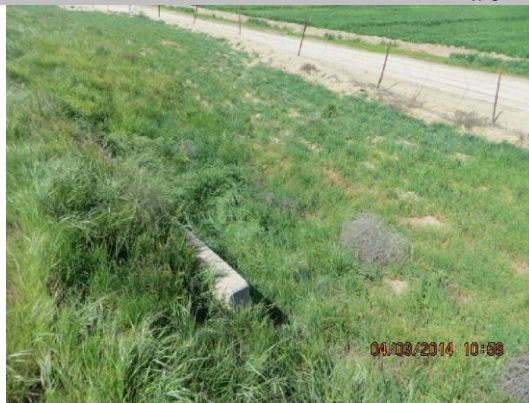
Photo 3 of 3 : UCIP\_SP\_2017\_39545\_59818.jpg

Concrete headwall on LS toe.

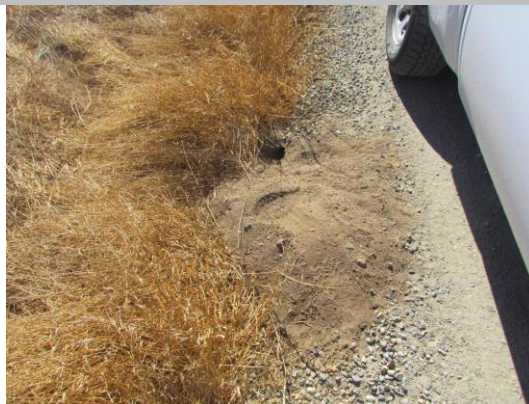
Photo 1 of 1 : SP\_2017\_NA0010\_139\_25\_20170417\_00025.jpg

LM Start	8.97	Rating **	U	Issue No.	25
LM End	8.97	Issue Type +	Ma	Location *	WS
Category	Earthen Levee			GPS Latitude/Longitude	
				Start	End
Item	Animal Control			36.799606 °	36.799606 °
				-120.175395 °	-120.175395 °
DWR ID	DWR_NA0010_23_f_2016_25				
Comment Code					
A3 : No rodents visible, but rodent burrows visible; need to backfill and compact or grout burrows.					
Inspector Comment					
Rodent holes on waterward shoulder.

Looking at typical view of rodent hole on waterward shoulder.

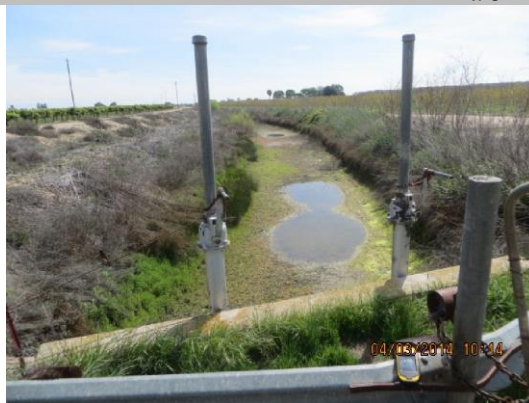
Photo 1 of 3 : UCIP\_SP\_2017\_49971\_59810.jpg

Comment Code					
Inspector Comment					
FS_ID:49971 DS_ID:19943 EP_NO: N/A Repair Type: Urgent Crossing Status: Found UCIP Comments: 7/20/2016 No change--same as previous inspection. (DWR UCIP - omagana)4/03/2014 Slide gate not functional. Slide gate channels heavily corroded (exfoliated) and likely impact functionality/structural integrity of gate. (DWR UCIP - omagana) FIELD_STRUCT_DESC: [Gravelly Ford Canal Irrigation Structure] 1 of 2: 5.25-foot by 4-foot reinforced concrete box culvert (RCBC) through the levee, 10 feet below the crown. Concrete "U" headwall on the waterside (WS) end. Gear pedestal slide gate with wall bracket is located on the WS headwall. Concrete "U" headwall is located on the landside (LS) end. Outlet channel cobble revetted 10 feet long. Guard rails are located on both shoulders. Slide gates are located on the WS. [Additional Reference(s): DWR Levee Log, 2002. USACE San Joaquin O&M Manuals: Unit No. 601, 1967, (HLM 9.76), Unit No. 601 Part I, 1967 (Amended in 1978), Unit No. 601 Part II, 1969, and Unit No. 601 Part III, 1969] FS Date: 7/20/2016

Slide gate actuator visible on WS shoulder with concrete headwall.

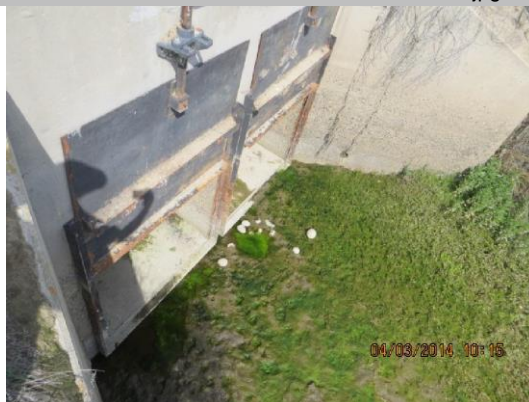
Photo 2 of 3 : UCIP\_SP\_2017\_49971\_59809.jpg

Slide gate on concrete headwall at WS toe.

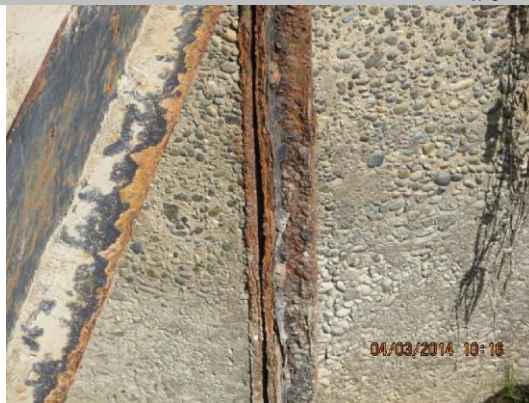
Photo 3 of 3 : UCIP\_SP\_2017\_49971\_59808.jpg

Comment Code					
Inspector Comment					
FS_ID:49971 DS_ID:19943 EP_NO: N/A Repair Type: Urgent Crossing Status: Found UCIP Comments: 7/20/2016 No change--same as previous inspection. (DWR UCIP - omagana)4/03/2014 Slide gate not functional. Slide gate channels heavily corroded (exfoliated) and likely impact functionality/structural integrity of gate. (DWR UCIP - omagana) FIELD_STRUCT_DESC: [Gravelly Ford Canal Irrigation Structure] 1 of 2: 5.25-foot by 4-foot reinforced concrete box culvert (RCBC) through the levee, 10 feet below the crown. Concrete "U" headwall on the waterside (WS) end. Gear pedestal slide gate with wall bracket is located on the WS headwall. Concrete "U" headwall is located on the landside (LS) end. Outlet channel cobble revetted 10 feet long. Guard rails are located on both shoulders. Slide gates are located on the WS. [Additional Reference(s): DWR Levee Log, 2002. USACE San Joaquin O&M Manuals: Unit No. 601, 1967, (HLM 9.76), Unit No. 601 Part I, 1967 (Amended in 1978), Unit No. 601 Part II, 1969, and Unit No. 601 Part III, 1969] FS Date: 7/20/2016

Heavy corrosion in slide gate tracks on WS toe.

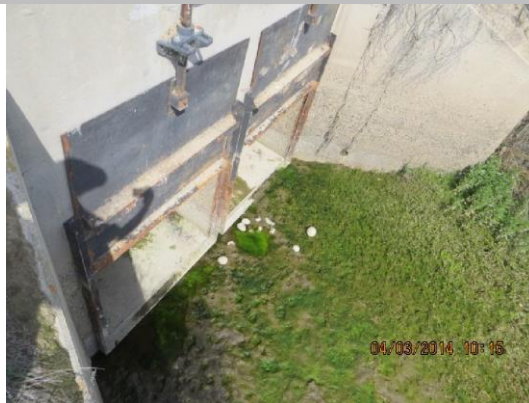
Photo 2 of 3 : UCIP\_SP\_2017\_49972\_59801.jpg

FS\_ID:49972  
DS\_ID:19980  
EP\_NO: N/A  
Repair Type: Urgent  
Crossing Status: Found  
UCIP Comments: 7/20/2016 No change--same as previous inspection. (DWR UCIP - omagana)4/03/2014 Slide gate not functional. Slide gate channels heavily corroded (exfoliated) and likely impact functionality/structural integrity of gate. (DWR UCIP - omagana)  
FIELD\_STRUCT\_DESC: [Gravelly Ford Canal Irrigation Structure] 2 of 2: 48-inch by 63-inch reinforced concrete box culvert (RCBC) through the levee, 10 feet below the crown. Concrete "U" headwall is located on the waterside (WS) end. Gear pedestal slide gate with wall bracket is located on the WS headwall. Concrete "U" headwall is located on the landside (LS) end. Outlet channel cobble revetted 10 feet long. Guardrails are located on both shoulders. [Additional Reference(s): DWR Levee Log, 2002]  
FS Date: 7/20/2016

Slide gates on WS toe.

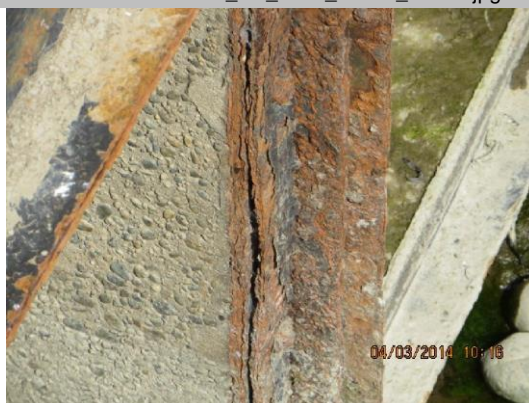
Photo 3 of 3 : UCIP\_SP\_2017\_49972\_59800.jpg

Comment Code					
Inspector Comment					
FS_ID:49972 DS_ID:19980 EP_NO: N/A Repair Type: Urgent Crossing Status: Found UCIP Comments: 7/20/2016 No change--same as previous inspection. (DWR UCIP - omagana)4/03/2014 Slide gate not functional. Slide gate channels heavily corroded (exfoliated) and likely impact functionality/structural integrity of gate. (DWR UCIP - omagana) FIELD_STRUCT_DESC: [Gravelly Ford Canal Irrigation Structure] 2 of 2: 48-inch by 63-inch reinforced concrete box culvert (RCBC) through the levee, 10 feet below the crown. Concrete "U" headwall is located on the waterside (WS) end. Gear pedestal slide gate with wall bracket is located on the WS headwall. Concrete "U" headwall is located on the landside (LS) end. Outlet channel cobble revetted 10 feet long. Guardrails are located on both shoulders. [Additional Reference(s): DWR Levee Log, 2002] FS Date: 7/20/2016

Slide gate tracks show heavy corrosion impacting actuation of slide gate.

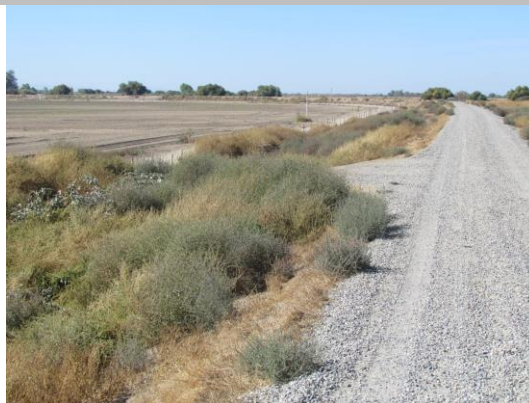
Photo 1 of 1 : SP\_2017\_NA0010\_140\_13\_20170417\_00005.jpg

LM Start	0.00	Rating **	M	Issue No.	13
LM End	5.85	Issue Type +	Ma	Location *	LS
Category	Earthen Levee			GPS Latitude/Longitude	
				Start	End
Item	Vegetation			36.773207 °	36.786728 °
				-120.285217 °	-120.218070 °
DWR ID	DWR_NA0010_24_f_2016_13				
Comment Code					
V1 : Control annual grass and weeds on the levee slopes and easements.					
Inspector Comment

Looking at typical view of dense veg on landward slope.

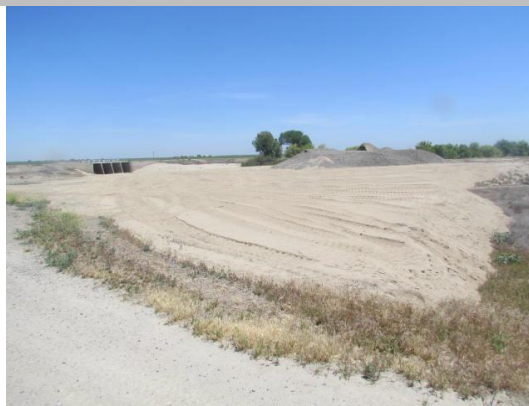
Photo 1 of 2 : SP\_2017\_NA0010\_140\_47\_20170417\_00007.jpg

LM Start	0.06	Rating **	M	Issue No.	47
LM End	0.06	Issue Type +	En	Location *	WS
Category	Earthen Levee			GPS Latitude/Longitude	
				Start	End
Item	Encroachments			36.772328 °	36.772328 °
				-120.285117 °	-120.285117 °
DWR ID	DWR_NA0010_24_s_2014_47				
Comment Code					
MA : Material					
Inspector Comment					
District constructed a berm on waterward slope. Berm is being used for staging of earthen material.

Looking northeast at berm on waterward slope.

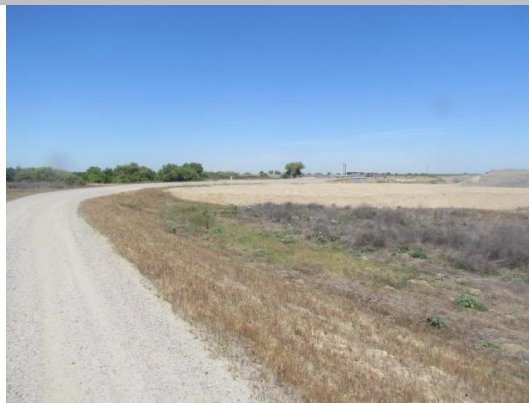
Photo 2 of 2 : SP\_2017\_NA0010\_140\_47\_20170417\_00008.jpg

Looking north at berm on waterward slope.

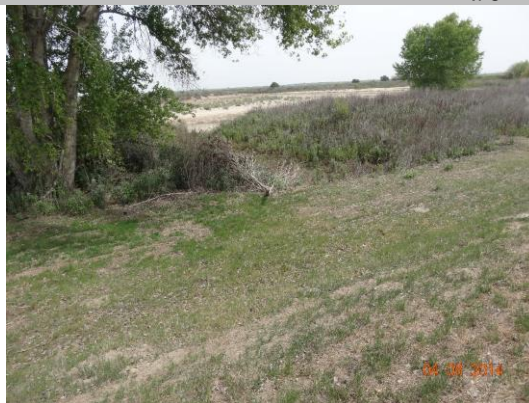
Photo 1 of 3 : UCIP\_SP\_2017\_33264\_60059.jpg

LM Start	0.50	Rating **	M	Issue No.	267
LM End	0.50	Issue Type +	En	Location *	WS
Category	Supplemental			GPS Latitude/Longitude	
				Start	End
Item	DWR UCIP Field Study			36.766872 °	36.766872 °
				-120.283212 °	-120.283212 °
DWR ID					
Comment Code					
Inspector Comment					
FS_ID:33264					
DS_ID:19955					
EP_NO: N/A					
Repair Type: Non-Urgent					
Crossing Status: Found					
UCIP Comments: No access available to confirm condition of landward side headwall. Recommend clearing debris along fence. Surface erosion near concrete headwall on landward side was present.					
FIELD_STRUCT_DESC: 30-inch square R.C.B.C. through the levee, 13.5 feet below the crown. Concrete headwalls on both ends. Flap gate on the waterward end.					
FS Date: 4/8/2014

View of waterward side.

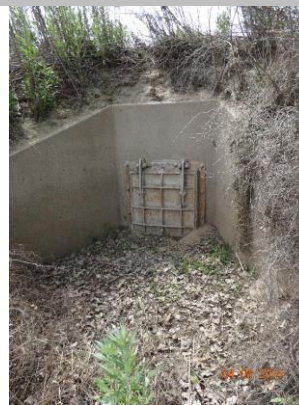
Photo 2 of 3 : UCIP\_SP\_2017\_33264\_60057.jpg

Square gate visible on waterward side.

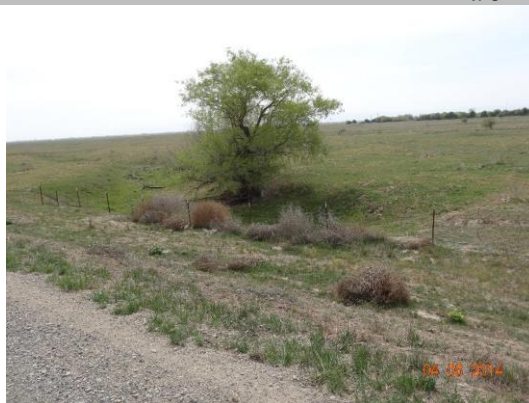
Photo 3 of 3 : UCIP\_SP\_2017\_33264\_60058.jpg

LM Start	0.50	Rating **	M	Issue No.	267 (cont)	
LM End	0.50	Issue Type +	En	Location *	WS	
Category	Supplemental			GPS Latitude/Longitude		
				Start	End	
Item	DWR UCIP Field Study			36.766872 °	36.766872 °	
				-120.283212 °	-120.283212 °	
DWR ID						
Comment Code						
Inspector Comment						
FS_ID:33264						
DS_ID:19955						
EP_NO: N/A						
Repair Type: Non-Urgent						
Crossing Status: Found						
UCIP Comments: No access available to confirm condition of landward side headwall. Recommend clearing debris along fence. Surface erosion near concrete headwall on landward side was present.						
FIELD_STRUCT_DESC: 30-inch square R.C.B.C. through the levee, 13.5 feet below the crown. Concrete headwalls on both ends. Flap gate on the waterward end.						
FS Date: 4/8/2014

View of landward side.

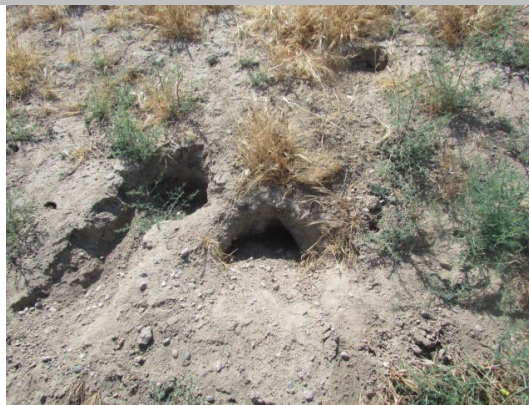
Photo 1 of 1 : SP\_2017\_NA0010\_140\_6\_20170417\_00002.jpg

LM Start	0.82	Rating **	M	Issue No.	6
LM End	0.82	Issue Type +	Ma	Location *	LS
Category	Earthen Levee			GPS Latitude/Longitude	
				Start	End
Item	Animal Control			36.766775 °	36.766775 °
				-120.278757 °	-120.278757 °
DWR ID	DWR_NA0010_24_s_2013_6				
Comment Code					
A1 : Exterminate rodents and backfill and compact or grout burrows.					
Inspector Comment					
Noted several rodent holes within this section.

Looking at several rodent holes on landward slope.

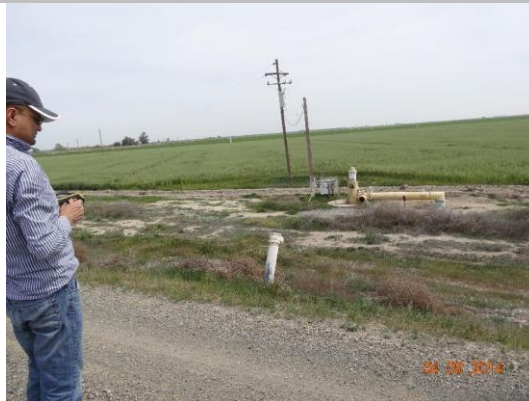
Photo 1 of 2 : UCIP\_SP\_2017\_33265\_60065.jpg

LM Start	1.06	Rating **	M	Issue No.	268
LM End	1.06	Issue Type +	En	Location *	LS
Category	Supplemental			GPS Latitude/Longitude	
				Start	End
Item	DWR UCIP Field Study			36.769574 °	36.769574 °
				-120.276253 °	-120.276253 °
DWR ID					
Comment Code					
Inspector Comment					
FS_ID:33265 DS_ID:19961 EP_NO: 13735 Repair Type: Non-Urgent Crossing Status: Found UCIP Comments: Unable to determine status of crossing. Need to contact owner to determine status of crossing. FIELD_STRUCT_DESC: 24-inch steel discharge pipe through the levee, 2-feet below the crown. Roadway on crown has been padded 1-foot. Siphon breaker on the apex of pipeline on landward shoulder. Galvanized siphon vent pipe on the landward shoulder. Steel cutoff wall around the pipeline at centerline of levee. Pump on landward side. (Permit No. 13735-1984). FS Date: 4/8/2014

View of landward side.

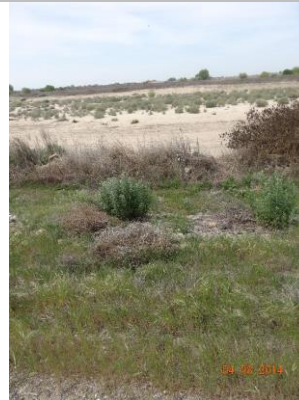
Photo 2 of 2 : UCIP\_SP\_2017\_33265\_60064.jpg

View of waterward side.

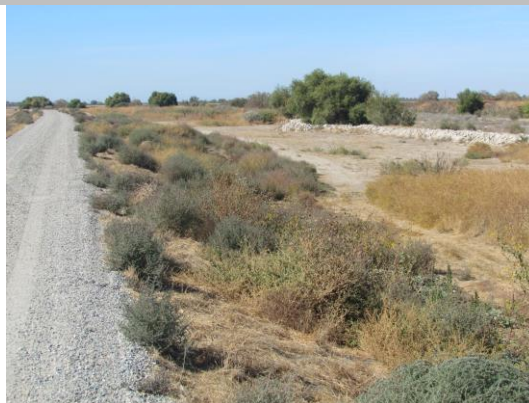
Photo 1 of 1 : SP\_2017\_NA0010\_140\_12\_20170417\_00004.jpg

LM Start	1.56	Rating **	M	Issue No.	12
LM End	8.35	Issue Type +	Ma	Location *	WS
Category	Earthen Levee			GPS Latitude/Longitude	
				Start	End
Item	Vegetation			36.770759 °	36.778347 °
				-120.269522 °	-120.184125 °
DWR ID	DWR_NA0010_24_f_2016_12				
Comment Code					
V1 : Control annual grass and weeds on the levee slopes and easements.					
Inspector Comment

Looking at typical view of dense veg on waterward slope.

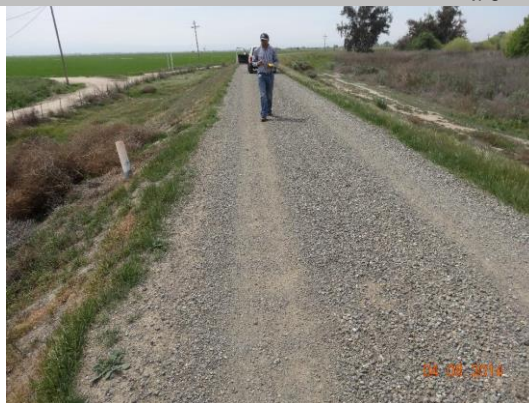
Photo 1 of 3 : UCIP\_SP\_2017\_33266\_60069.jpg

LM Start	1.75	Rating **	M	Issue No.	269
LM End	1.75	Issue Type +	En	Location *	WS
Category	Supplemental			GPS Latitude/Longitude	
				Start	End
Item	DWR UCIP Field Study			36.771065 °	36.771065 °
				-120.266294 °	-120.266294 °
DWR ID					
Comment Code					
Inspector Comment					
FS_ID:33266 DS_ID:19962 EP_NO: 13085 Repair Type: Non-Urgent Crossing Status: Indicator Found UCIP Comments: Need to contact owner to determine status. FIELD_STRUCT_DESC: 20-inch steel discharge pipe through the levee, 2-feet below the crown. Siphon breaker installed on apex of pipe on the landward shoulder. Steel cutoff wall placed around pipeline at each shoulder. Pipeline encased through the levee crown in concrete. Vent pipe on landward side. Rock riprap on the waterward levee slope. (Permit No. 13085-1981). FS Date: 4/8/2014

Overview of levee crown at crossing.

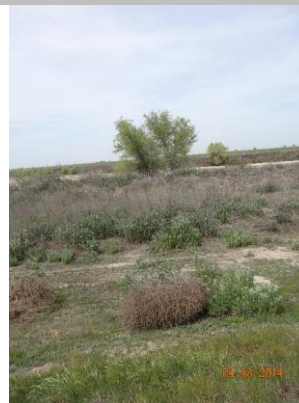
Photo 2 of 3 : UCIP\_SP\_2017\_33266\_60070.jpg

Item	DWR UCIP Field Study			36.771065 °		36.771065 °
				-120.266294 °		-120.266294 °
DWR ID						
Comment Code						
Inspector Comment						
FS_ID:33266						
DS_ID:19962						
EP_NO: 13085						
Repair Type: Non-Urgent						
Crossing Status: Indicator Found						
UCIP Comments: Need to contact owner to determine status.						
FIELD_STRUCT_DESC: 20-inch steel discharge pipe through the						
levee, 2-feet below the crown. Siphon breaker installed on apex of pipe						
on the landward shoulder. Steel cutoff wall placed around pipeline at						
each shoulder. Pipeline encased through the levee crown in concrete.						
Vent pipe on landward side. Rock riprap on the waterward levee slope.						
(Permit No. 13085-1981).						
FS Date: 4/8/2014

View of waterward side.

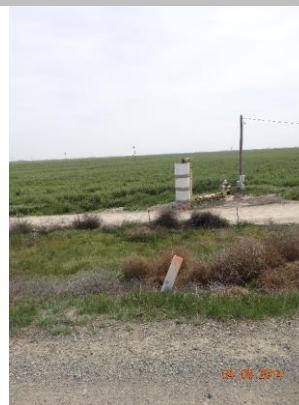
Photo 3 of 3 : UCIP\_SP\_2017\_33266\_60071.jpg

View of landward side.

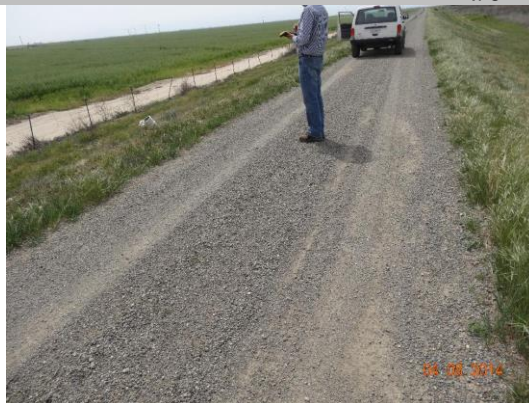
Photo 1 of 3 : UCIP\_SP\_2017\_33267\_60075.jpg

LM Start	2.69	Rating **	M	Issue No.	270
LM End	2.69	Issue Type +	En	Location *	WS
Category	Supplemental			GPS Latitude/Longitude	
				Start	End
Item	DWR UCIP Field Study			36.771742 °	36.771742 °
				-120.250929 °	-120.250929 °
DWR ID					
Comment Code					
Inspector Comment					
FS_ID:33267					
DS_ID:19963					
EP_NO: 13735					
Repair Type: Non-Urgent					
Crossing Status: Found					
UCIP Comments: Unable to confirm status of crossing.					
FIELD_STRUCT_DESC: 24-inch steel discharge pipe through the					
levee, 2-feet below the crown. Roadway on crown has been padded 1-					
foot. Siphon breaker on the apex of pipeline on landward shoulder.					
Galvanized siphon vent pipe on the landward shoulder. Steel cutoff wall					
around the pipeline at centerline of levee. Pump on landward side.					
(Permit No. 13735-1984).					
FS Date: 4/8/2014

Overview of levee crown at crossing.

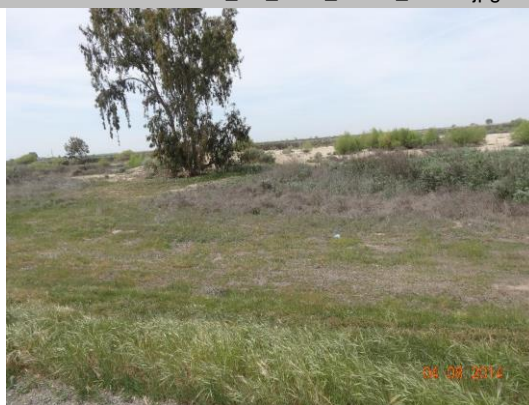
Photo 2 of 3 : UCIP\_SP\_2017\_33267\_60076.jpg

View of waterward side.

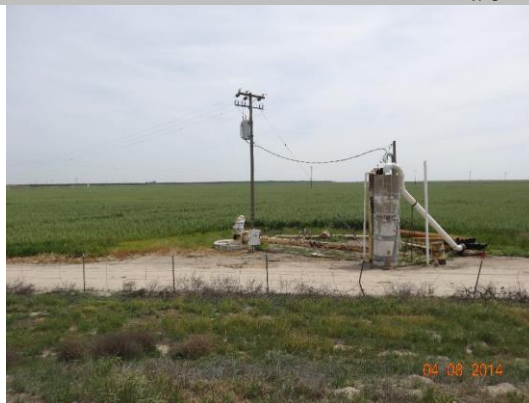
Photo 3 of 3 : UCIP\_SP\_2017\_33267\_60077.jpg

LM Start	2.69	Rating **	M	Issue No.	270 (cont)
LM End	2.69	Issue Type +	En	Location *	WS
Category	Supplemental			GPS Latitude/Longitude	
				Start	End
Item	DWR UCIP Field Study			36.771742 °	36.771742 °
				-120.250929 °	-120.250929 °
DWR ID					
Comment Code					
Inspector Comment					
FS_ID:33267 DS_ID:19963 EP_NO: 13735 Repair Type: Non-Urgent Crossing Status: Found UCIP Comments: Unable to confirm status of crossing. FIELD_STRUCT_DESC: 24-inch steel discharge pipe through the levee, 2-feet below the crown. Roadway on crown has been padded 1-foot. Siphon breaker on the apex of pipeline on landward shoulder. Galvanized siphon vent pipe on the landward shoulder. Steel cutoff wall around the pipeline at centerline of levee. Pump on landward side. (Permit No. 13735-1984). FS Date: 4/8/2014

View of landward side.

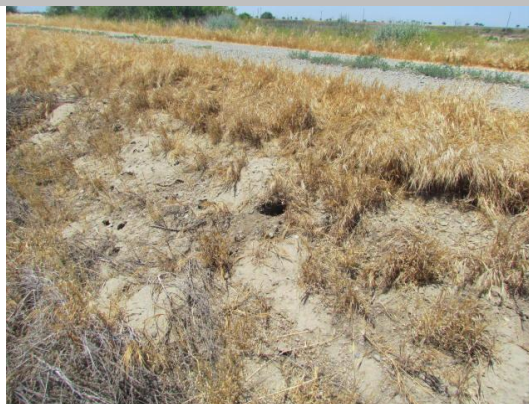
Photo 1 of 1 : SP\_2017\_NA0010\_140\_7\_20170417\_00003.jpg

LM Start	3.46	Rating **	M	Issue No.	7
LM End	3.46	Issue Type +	Ma	Location *	LS
Category	Earthen Levee			GPS Latitude/Longitude	
				Start	End
Item	Animal Control			36.769345 °	36.769345 °
				-120.238370 °	-120.238370 °
DWR ID	DWR_NA0010_24_s_2012_7				
Comment Code					
A3 : No rodents visible, but rodent burrows visible; need to backfill and compact or grout burrows.					
Inspector Comment					
One of several rodent holes on landward slope.

Looking east at one of several rodent holes on landward slope.

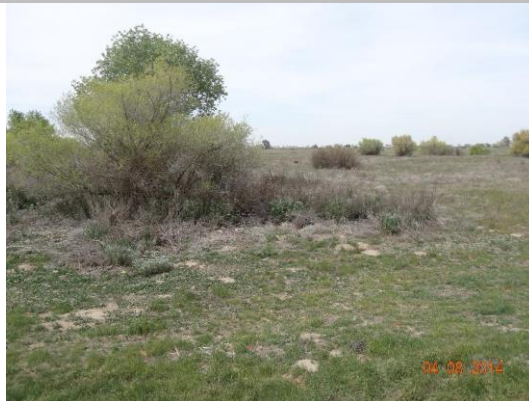
Photo 1 of 3 : UCIP\_SP\_2017\_36849\_67237.jpg

LM Start	4.06	Rating **	M	Issue No.	271
LM End	4.06	Issue Type +	En	Location *	LS
Category	Supplemental			GPS Latitude/Longitude	
				Start	End
Item	DWR UCIP Field Study			36.769238 °	36.769238 °
				-120.228588 °	-120.228588 °
DWR ID					
Comment Code					
Inspector Comment					
FS_ID:36849 DS_ID:19964 EP_NO: N/A Repair Type: Non-Urgent Crossing Status: Found UCIP Comments: Unable to confirm crossing alignment and appurtenances associated with this crossing. Multiple stand pipes visible on landward side. Need to contact owner to determine status of crossing and alignment. FIELD_STRUCT_DESC: 30-inch square R.C.B.C. through the levee 12.5 feet below the crown. Concrete riser unit with slide gate on the waterward slope. Screw gate on landward shoulder. Pump on landward side. Rehabilitation of crossing under Permit No. 13085 (1981). FS Date: 4/8/2014

View of waterward side.

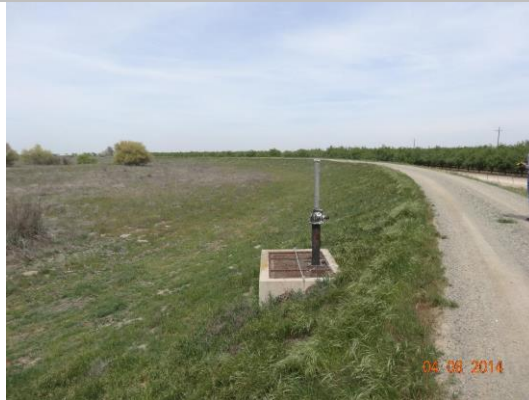
Photo 2 of 3 : UCIP\_SP\_2017\_36849\_67236.jpg

Slide gate inside concrete box located on waterward side.

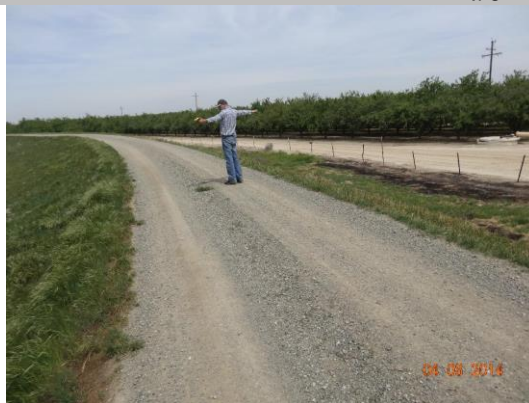
Photo 3 of 3 : UCIP\_SP\_2017\_36849\_67235.jpg

LM Start	4.06	Rating **	M	Issue No.	271 (cont)	
LM End	4.06	Issue Type +	En	Location *	LS	
Category	Supplemental			GPS Latitude/Longitude		
				Start		End
Item	DWR UCIP Field Study			36.769238 °	36.769238 °	
				-120.228588 °	-120.228588 °	
DWR ID						
Comment Code						
Inspector Comment						
FS_ID:36849 DS_ID:19964 EP_NO: N/A Repair Type: Non-Urgent Crossing Status: Found UCIP Comments: Unable to confirm crossing alignment and appurtenances associated with this crossing. Multiple stand pipes visible on landward side. Need to contact owner to determine status of crossing and alignment. FIELD_STRUCT_DESC: 30-inch square R.C.B.C. through the levee 12.5 feet below the crown. Concrete riser unit with slide gate on the waterward slope. Screw gate on landward shoulder. Pump on landward side. Rehabilitation of crossing under Permit No. 13085 (1981). FS Date: 4/8/2014

Overview of levee at crossing.
