**Flood Control Project Maintenance  
Levee Inspections**  
**LMA District Cover Sheet**  
**Spring 2017 Levee Inspection Results**

**Lower San Joaquin Levee District**

Waterway			Bank	Unit Miles
Unit No. 01 San Joaquin River			Right	22.52
	Spring (March - May)	Summer (June - August)	(September - November) Fall	Winter (December - February)
Unit Maintenance Rating (Fall Only)				
Date of Inspection	4/17/2017 - 4/20/2017			
DWR Inspector	Richard Willoughby			
Accompanied By

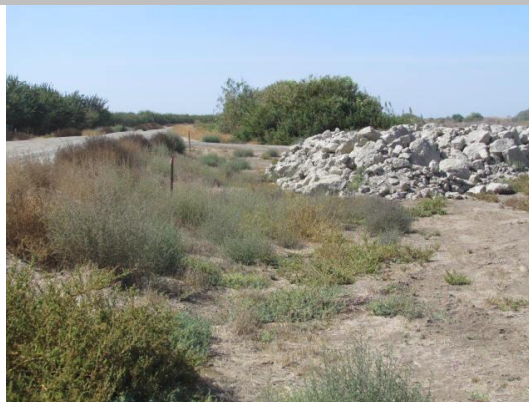
Photo 1 of 2 : SP\_2017\_NA0010\_140\_266\_20170417\_00009.jpg

LM Start	5.40	Rating **	M	Issue No.	266
LM End	5.40	Issue Type +	En	Location *	WS
Category	Earthen Levee			GPS Latitude/Longitude	
				Start	End
Item	Encroachments			36.782405 °	36.782405 °
				-120.222763 °	-120.222763 °
DWR ID	DWR_NA0010_24_s_2015_266				
Comment Code					
MA : Material					
Inspector Comment					
Rocks stockpile near waterward toe.

Looking at rock stockpile on waterward berm. Fall 2015

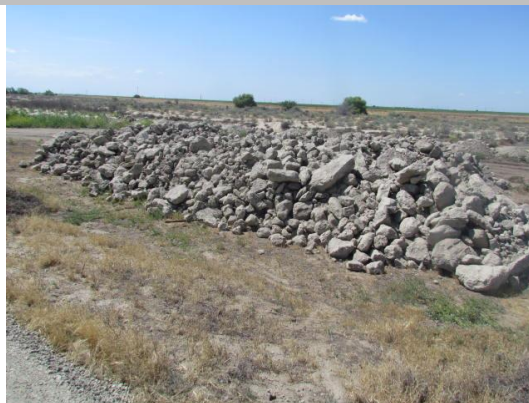
Photo 2 of 2 : SP\_2017\_NA0010\_140\_266\_20170417\_00010.jpg

LM Start	5.40	Rating **	M	Issue No.	266 (cont)	
LM End	5.40	Issue Type +	En	Location *	WS	
Category	Earthen Levee			GPS Latitude/Longitude		
				Start	End	
Item	Encroachments			36.782405 °	36.782405 °	
				-120.222763 °	-120.222763 °	
DWR ID	DWR_NA0010_24_s_2015_266					
Comment Code						
MA : Material						
Inspector Comment						
Rocks stockpile near waterward toe.

Looking north at rock pile on waterward berm.

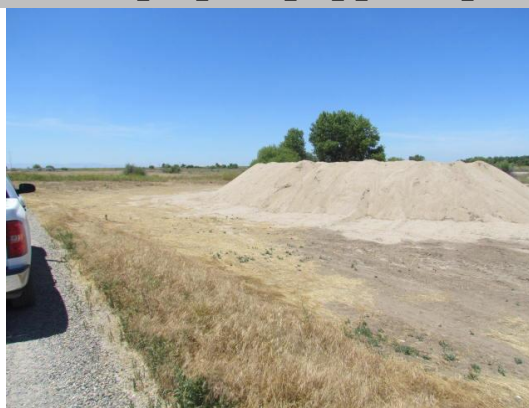
Photo 1 of 1 : SP\_2017\_NA0010\_140\_2\_20170417\_00001.jpg

LM Start	6.15	Rating **	U	Issue No.	2
LM End	6.15	Issue Type +	En	Location *	WS
Category	Earthen Levee			GPS Latitude/Longitude	
				Start	End
Item	Encroachments			36.788088 °	36.788088 °
				-120.212827 °	-120.212827 °
DWR ID	DWR_NA0010_24_s_2016_2				
Comment Code					
MA : Material					
Inspector Comment					
Sand pile on waterward berm over three feet high and 25 feet away from waterward toe should be removed.

Looking northeast at sandpile over three on waterward berm.

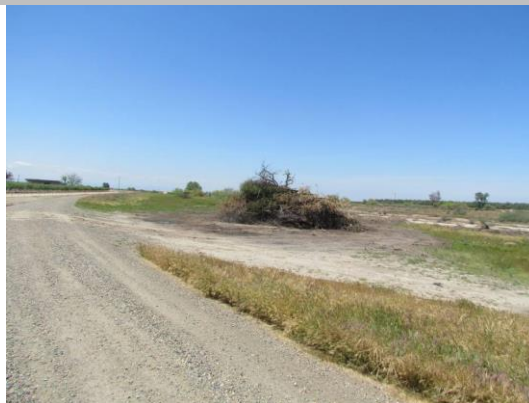
Photo 1 of 1 : SP\_2017\_NA0010\_140\_3\_20170425\_00030.jpg

LM Start	6.33	Rating **	U	Issue No.	3
LM End	6.33	Issue Type +	En	Location *	WS
Category	Earthen Levee			GPS Latitude/Longitude	
				Start	End
Item	Encroachments			36.788155 °	36.788155 °
				-120.209655 °	-120.209655 °
DWR ID	DWR_NA0010_24_s_2012_3				
Comment Code					
PR : Prunings					
Inspector Comment					
Large pruning pile in channel.

Looking downstream (north) at large pruning pile on waterward berm.

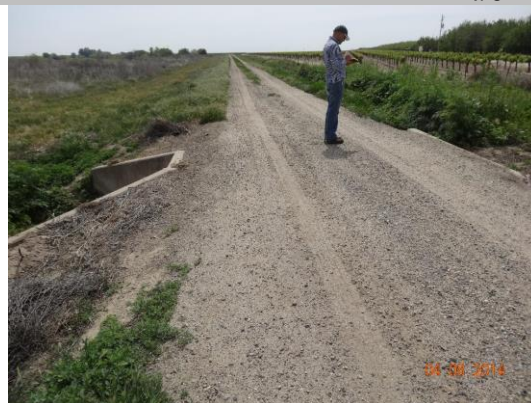
Photo 1 of 3 : UCIP\_SP\_2017\_50056\_60105.jpg

Comment Code					
Inspector Comment					
FS_ID:50056 DS_ID:19957 EP_NO: N/A Repair Type: Non-Urgent Crossing Status: Found UCIP Comments: 7/20/2016 same as previous inspection. Crossing has been downgraded from Urgent to Non-Urgent PVC does not prevent WS flap gate from closing. (DWR UCIP - omagana)4/08/2014 Unauthorized PVC pipe through existng crossing. PVC distorted inside--Need to contact owner to correct issue. If crossing was allowed need to contact owner for permit number issue for crossing variance. (DWR UCIP - omagana) FIELD_STRUCT_DESC: 24-inch corrugated metal drainage pipe through the levee, 3.6 feet below the crown. Concrete "U" headwall located on the waterside (WS) end. Flap gate is located on the WS end. Concrete headwall is located on the landside (LS) end. [Additional Reference(s): DWR Levee Log, 2002] FS Date: 7/20/2016

Overview of levee crown at crossing.

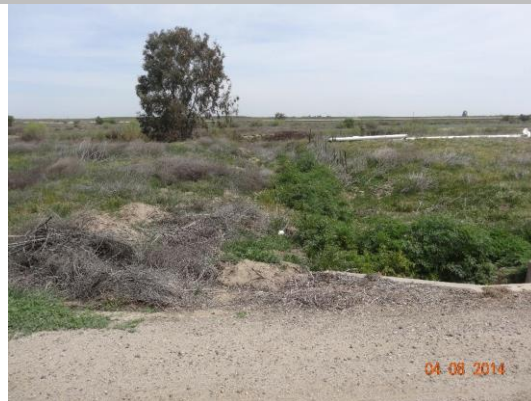
Photo 2 of 3 : UCIP\_SP\_2017\_50056\_60107.jpg

View of WS--debris (pipe sections) located on waterward side.

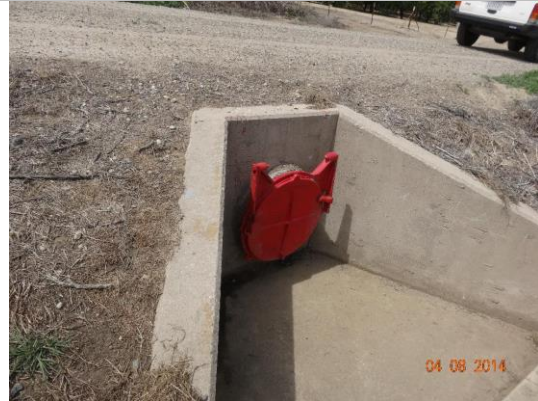
Photo 3 of 3 : UCIP\_SP\_2017\_50056\_60106.jpg

Comment Code					
Inspector Comment					
FS_ID:50056 DS_ID:19957 EP_NO: N/A Repair Type: Non-Urgent Crossing Status: Found UCIP Comments: 7/20/2016 same as previous inspection. Crossing has been downgraded from Urgent to Non-Urgent PVC does not prevent WS flap gate from closing. (DWR UCIP - omagana)4/08/2014 Unauthorized PVC pipe through existng crossing. PVC distorted inside--Need to contact owner to correct issue. If crossing was allowed need to contact owner for permit number issue for crossing variance. (DWR UCIP - omagana) FIELD_STRUCT_DESC: 24-inch corrugated metal drainage pipe through the levee, 3.6 feet below the crown. Concrete "U" headwall located on the waterside (WS) end. Flap gate is located on the WS end. Concrete headwall is located on the landside (LS) end. [Additional Reference(s): DWR Levee Log, 2002] FS Date: 7/20/2016

Flap gate visible on WS.

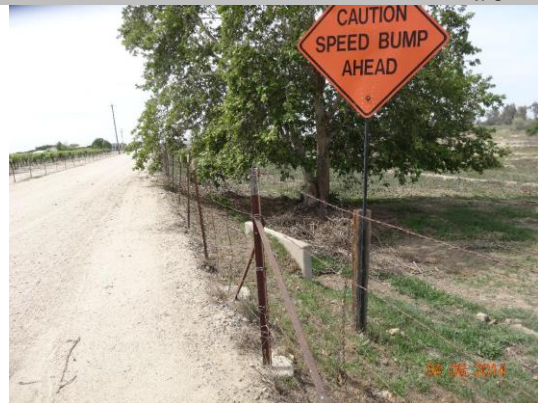
Photo 1 of 2 : UCIP\_SP\_2017\_33272\_60121.jpg

LM Start	8.33	Rating **	M	Issue No.	273
LM End	8.33	Issue Type +	Ma	Location *	LS
Category	Supplemental			GPS Latitude/Longitude	
				Start	End
Item	DWR UCIP LMA Responsibility			36.778084 °	36.778084 °
				-120.184454 °	-120.184454 °
DWR ID					
Comment Code					
Inspector Comment					
FS_ID:33272					
DS_ID:19960					
EP_NO: N/A					
Repair Type: Non-Urgent					
Crossing Status: Found					
UCIP Comments: Barbed wire along levee shoulder--no access. Need to confirm crossing size and condition of crossing.					
FIELD_STRUCT_DESC: 12-inch concrete pipe through the levee, 3.0 feet below the crown. Concrete headwall on the waterward end. Flap gate on the waterward end. (USACE-1967). This entry matches the Drainage or Irrigation Structure referenced in O&M manual (HLM 8.32).					
FS Date: 4/8/2014

View of waterward side.

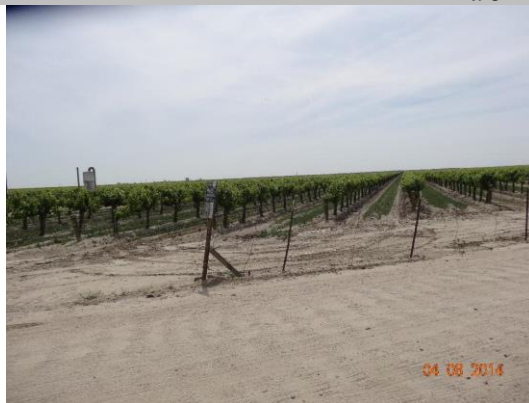
Photo 2 of 2 : UCIP\_SP\_2017\_33272\_60120.jpg

LM Start	8.33	Rating **	M	Issue No.	273 (cont)	
LM End	8.33	Issue Type +	Ma	Location *	LS	
Category	Supplemental			GPS Latitude/Longitude		
				Start	End	
Item	DWR UCIP LMA Responsibility			36.778084 °	36.778084 °	
				-120.184454 °	-120.184454 °	
DWR ID						
Comment Code						
Inspector Comment						
FS_ID:33272						
DS_ID:19960						
EP_NO: N/A						
Repair Type: Non-Urgent						
Crossing Status: Found						
UCIP Comments: Barbed wire along levee shoulder--no access. Need to confirm crossing size and condition of crossing.						
FIELD_STRUCT_DESC: 12-inch concrete pipe through the levee, 3.0 feet below the crown. Concrete headwall on the waterward end. Flap gate on the waterward end. (USACE-1967). This entry matches the Drainage or Irrigation Structure referenced in O&M manual (HLM 8.32).						
FS Date: 4/8/2014

View of landward side.

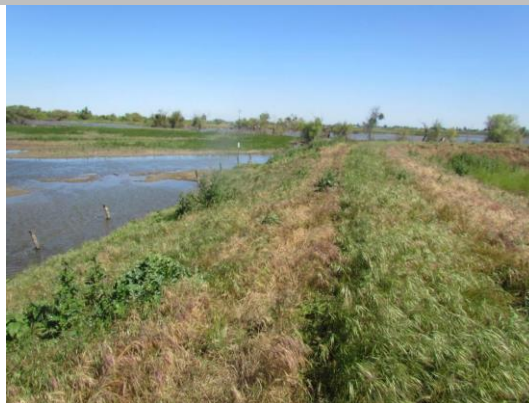
Photo 1 of 1 : SP\_2017\_NA0010\_141\_7\_20170425\_00025.jpg

LM Start	0.00	Rating **	U	Issue No.	7
LM End	2.48	Issue Type +	Ma	Location *	LS
Category	Earthen Levee			GPS Latitude/Longitude	
				Start	End
Item	Vegetation			37.296261 °	37.271165 °
				-120.880678 °	-120.866629 °
DWR ID	DWR_NA0010_25_f_2015_7				
Comment Code					
V2 : Remove the wild growth other than native grasses from the levee slopes.					
Inspector Comment

Looking at typical view of landward slope.

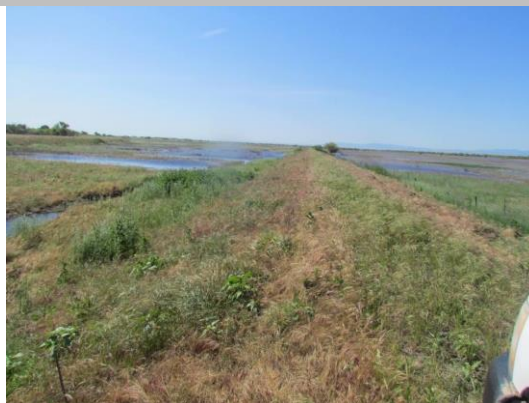
Photo 1 of 1 : SP\_2017\_NA0010\_141\_9\_20170425\_00026.jpg

LM Start	0.00	Rating **	U	Issue No.	9
LM End	2.49	Issue Type +	Ma	Location *	WS
Category	Earthen Levee			GPS Latitude/Longitude	
				Start	End
Item	Vegetation			37.296261 °	37.271117 °
				-120.880678 °	-120.866599 °
DWR ID	DWR_NA0010_25_f_2015_9				
Comment Code					
V2 : Remove the wild growth other than native grasses from the levee slopes.					
Inspector Comment

Looking typical view of waterward slope.

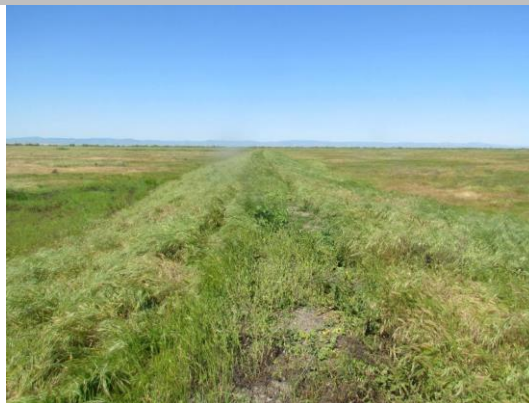
Photo 1 of 1 : SP\_2017\_NA0010\_141\_8\_20170425\_00027.jpg

LM Start	0.01	Rating **	U	Issue No.	8
LM End	1.76	Issue Type +	Ma	Location *	CR
Category	Earthen Levee			GPS Latitude/Longitude	
				Start	End
Item	Vegetation			37.296117 °	37.281615 °
				-120.880724 °	-120.867133 °
DWR ID	DWR_NA0010_25_s_2012_8				
Comment Code					
V2 : Remove the wild growth other than native grasses from the levee slopes.					
Inspector Comment					
Control weeds on levee crown.

Looking at typical view of levee crown.

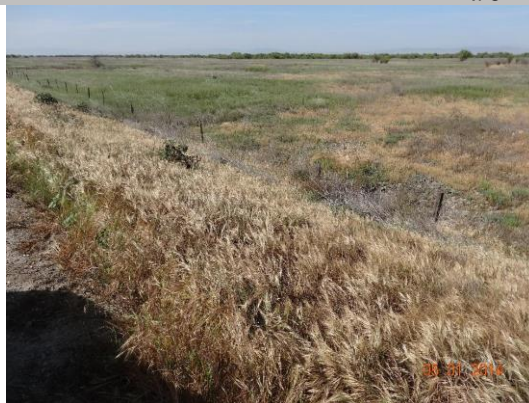
Photo 1 of 3 : UCIP\_SP\_2017\_39501\_67242.jpg

Comment Code					
Inspector Comment					
FS_ID:39501 DS_ID:19965 EP_NO: N/A Repair Type: Non-Urgent Crossing Status: Found UCIP Comments: Dense vegetation limits the inspectors visibility to identify signs of pipe failure (leaks) along the slope. Recommend removing vegetation along pipe alignment to conduct proper inspection of structure. Sediment buildup in pipe visible from landward side--recommend clearing. FIELD_STRUCT_DESC: 24-inch CM pipe through the levee, 10.0 feet below the crown. Flap gate on the waterward end. (USACE-1967). This entry matches the Drainage or Irrigation Structure referenced in O&M manual (HLM 0.02). FS Date: 5/1/2014

View of waterward side--dense vegetation on waterward side.

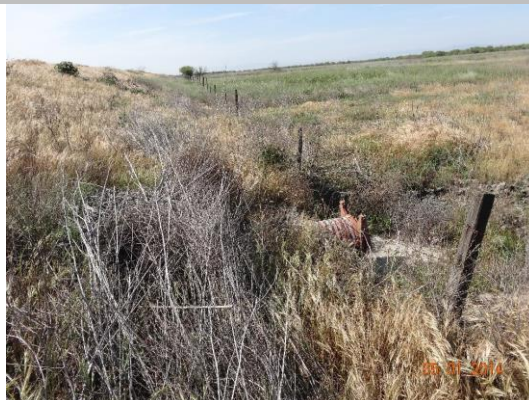
Photo 2 of 3 : UCIP\_SP\_2017\_39501\_67240.jpg

Pipe daylight visible on waterward toe.

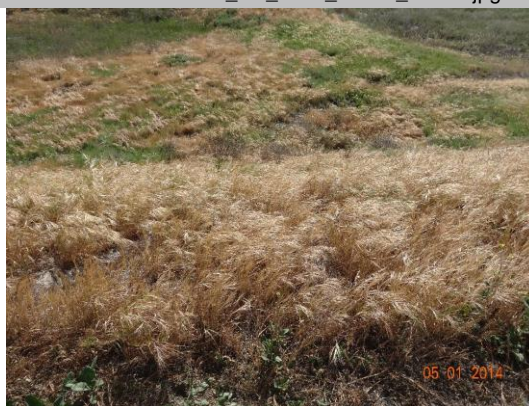
Photo 3 of 3 : UCIP\_SP\_2017\_39501\_67241.jpg

Comment Code						
Inspector Comment						
FS_ID:39501 DS_ID:19965 EP_NO: N/A Repair Type: Non-Urgent Crossing Status: Found UCIP Comments: Dense vegetation limits the inspectors visibility to identify signs of pipe failure (leaks) along the slope. Recommend removing vegetation along pipe alignment to conduct proper inspection of structure. Sediment buildup in pipe visible from landward side--recommend clearing. FIELD_STRUCT_DESC: 24-inch CM pipe through the levee, 10.0 feet below the crown. Flap gate on the waterward end. (USACE-1967). This entry matches the Drainage or Irrigation Structure referenced in O&M manual (HLM 0.02). FS Date: 5/1/2014

View of landward side--dense vegetation on landward side.

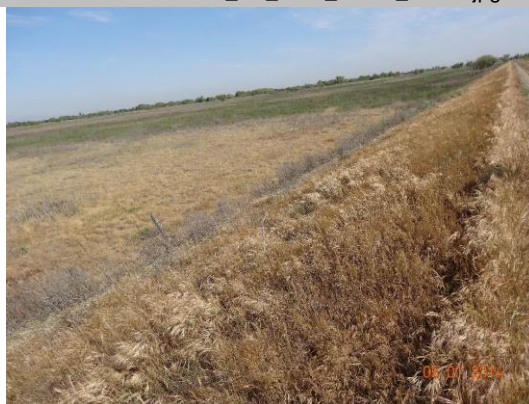
Photo 1 of 3 : UCIP\_SP\_2017\_36851\_67249.jpg

LM Start	0.36	Rating **	M	Issue No.	11
LM End	0.36	Issue Type +	Ma	Location *	CR
Category	Supplemental			GPS Latitude/Longitude	
				Start	End
Item	DWR UCIP LMA Responsibility			37.291173 °	37.291173 °
				-120.880731 °	-120.880731 °
DWR ID					
Comment Code					
Inspector Comment					
FS_ID:36851 DS_ID:19966 EP_NO: N/A Repair Type: Non-Urgent Crossing Status: Found UCIP Comments: Dense vegetation limits the inspectors visibility to identify signs of pipe failure (leaks) along the slope. Recommend removing vegetation along pipe alignment to conduct proper inspection of structure. FIELD_STRUCT_DESC: 24-inch CM pipe through the levee, 11.6 feet below the crown. Flap gate on the waterward end. (USACE-1967). This entry matches the Drainage or Irrigation Structure referenced in O&M manual (HLM 0.35). FS Date: 5/1/2014

View of waterward side.

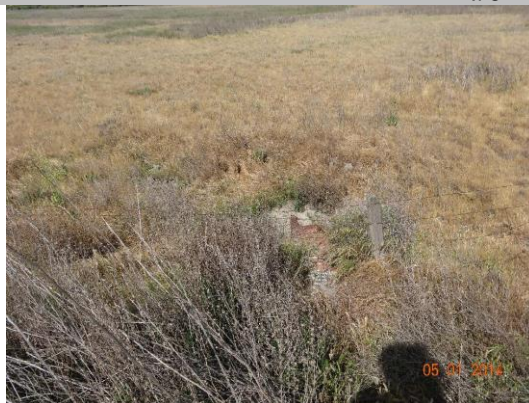
Photo 2 of 3 : UCIP\_SP\_2017\_36851\_67248.jpg

Pipe outlet visible on waterward side.

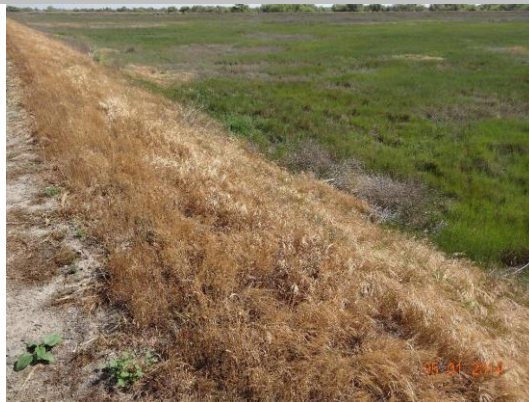
Photo 3 of 3 : UCIP\_SP\_2017\_36851\_67247.jpg

View of landward side.

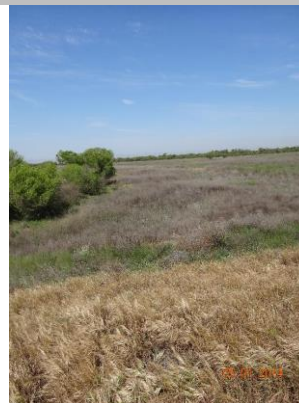
Photo 1 of 3 : UCIP\_SP\_2017\_36852\_67250.jpg

LM Start	0.59	Rating **	M	Issue No.	12
LM End	0.59	Issue Type +	Ma	Location *	CR
Category	Supplemental			GPS Latitude/Longitude	
				Start	End
Item	DWR UCIP LMA Responsibility			37.287744 °	37.287744 °
				-120.880645 °	-120.880645 °
DWR ID					
Comment Code					
Inspector Comment					
FS_ID:36852 DS_ID:19967 EP_NO: N/A Repair Type: Non-Urgent Crossing Status: Found UCIP Comments: Dense vegetation limits the inspectors visibility to identify signs of pipe failure (leaks) along the slope. Recommend removing vegetation along pipe alignment to conduct proper inspection of structure. FIELD_STRUCT_DESC: 24-inch CM pipe through the levee, 14.7 feet below the crown. Flap gate on the waterward end. (USACE-1967). This entry matches the Drainage or Irrigation Structure referenced in O&M manual (HLM 0.59). FS Date: 5/1/2014

Overview of waterward side--Salt Slough.

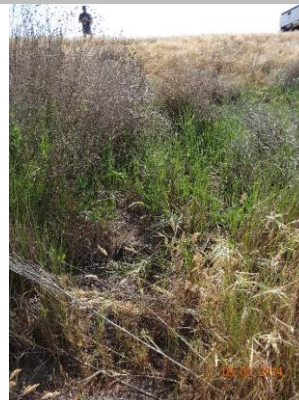
Photo 2 of 3 : UCIP\_SP\_2017\_36852\_67251.jpg

View of waterward slope covered by dense vegetation.

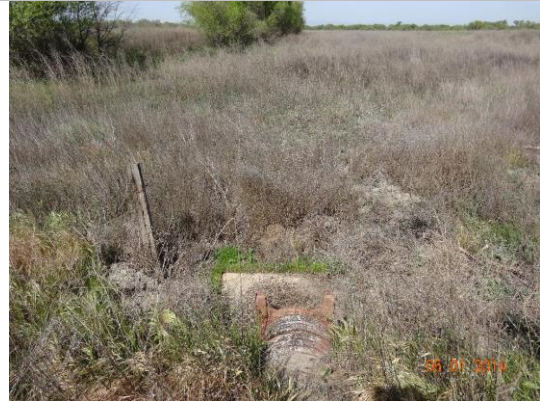
Photo 3 of 3 : UCIP\_SP\_2017\_36852\_67252.jpg

LM Start	0.59	Rating **	M	Issue No.	12 (cont)	
LM End	0.59	Issue Type +	Ma	Location *	CR	
Category	Supplemental			GPS Latitude/Longitude		
				Start	End	
Item	DWR UCIP LMA Responsibility			37.287744 °	37.287744 °	
				-120.880645 °	-120.880645 °	
DWR ID						
Comment Code						
Inspector Comment						
FS_ID:36852						
DS_ID:19967						
EP_NO: N/A						
Repair Type: Non-Urgent						
Crossing Status: Found						
UCIP Comments: Dense vegetation limits the inspectors visibility to identify signs of pipe failure (leaks) along the slope. Recommend removing vegetation along pipe alignment to conduct proper inspection of structure.						
FIELD_STRUCT_DESC: 24-inch CM pipe through the levee, 14.7 feet below the crown. Flap gate on the waterward end. (USACE-1967). This entry matches the Drainage or Irrigation Structure referenced in O&M manual (HLM 0.59).						
FS Date: 5/1/2014

Pipe and flap gate visible on waterward side.

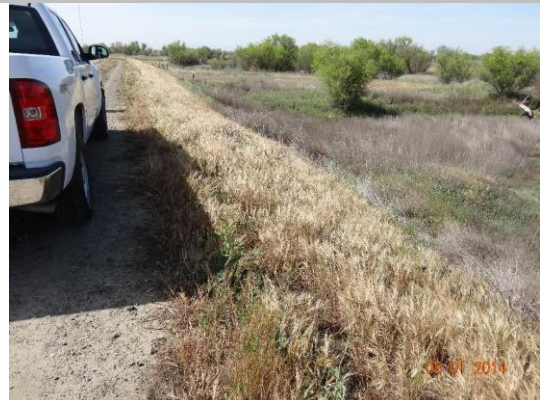
Photo 1 of 3 : UCIP\_SP\_2017\_36853\_67256.jpg

LM Start	0.97	Rating **	M	Issue No.	13
LM End	0.97	Issue Type +	Ma	Location *	CR
Category	Supplemental			GPS Latitude/Longitude	
				Start	End
Item	DWR UCIP LMA Responsibility			37.282252 °	37.282252 °
				-120.880738 °	-120.880738 °
DWR ID					
Comment Code					
Inspector Comment					
FS_ID:36853 DS_ID:19968 EP_NO: N/A Repair Type: Non-Urgent Crossing Status: Found UCIP Comments: Dense vegetation limits the inspectors visibility to identify signs of pipe failure (leaks) along the slope. Recommend removing vegetation along pipe alignment to conduct proper inspection of structure. FIELD_STRUCT_DESC: 24-inch CM pipe through the levee, 11.4 feet below the crown. Flap gate on the waterward end. (USACE-1967). This entry matches the Drainage or Irrigation Structure referenced in O&M manual (HLM 0.97). FS Date: 5/1/2014

View of waterward side.

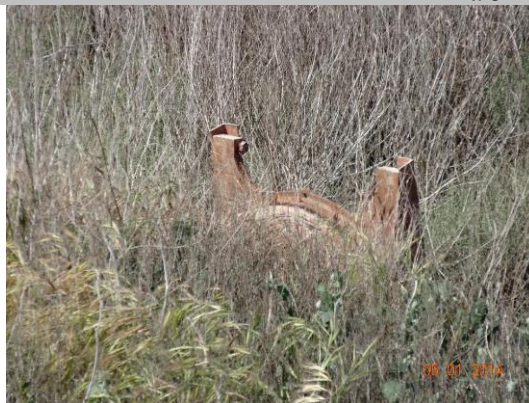
Photo 2 of 3 : UCIP\_SP\_2017\_36853\_67255.jpg

Pipe and evidence of flap gate visible on waterward side.

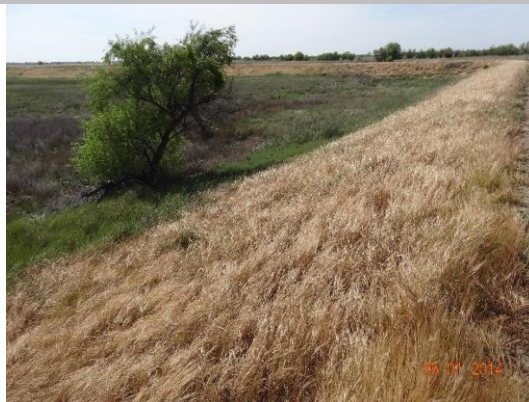
Photo 3 of 3 : UCIP\_SP\_2017\_36853\_67254.jpg

View of landward side.

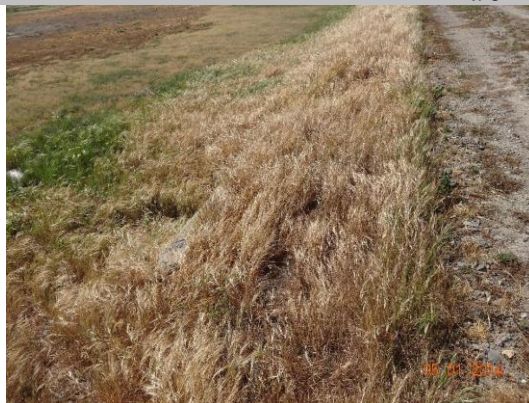
Photo 1 of 3 : UCIP\_SP\_2017\_36854\_67259.jpg

LM Start	2.05	Rating **	M	Issue No.	14
LM End	2.05	Issue Type +	Ma	Location *	CR
Category	Supplemental			GPS Latitude/Longitude	
				Start	End
Item	DWR UCIP LMA Responsibility			37.277390 °	37.277390 °
				-120.867184 °	-120.867184 °
DWR ID					
Comment Code					
Inspector Comment					
FS_ID:36854 DS_ID:19969 EP_NO: N/A Repair Type: Non-Urgent Crossing Status: Found UCIP Comments: Dense vegetation limits the inspectors visibility to identify signs of pipe failure (leaks) along the slope. Recommend removing vegetation along pipe alignment to conduct proper inspection of structure. FIELD_STRUCT_DESC: 24-inch CM pipe through the levee, 4.0 feet below the crown. Flap gate on the waterward end. (USACE-1967). This entry matches the Drainage or Irrigation Structure referenced in O&M manual (HLM 2.05). FS Date: 5/1/2014

View of landward side.

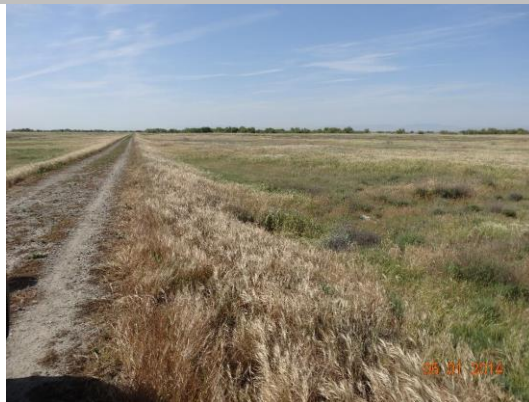
Photo 2 of 3 : UCIP\_SP\_2017\_36854\_67260.jpg

View of waterward side.

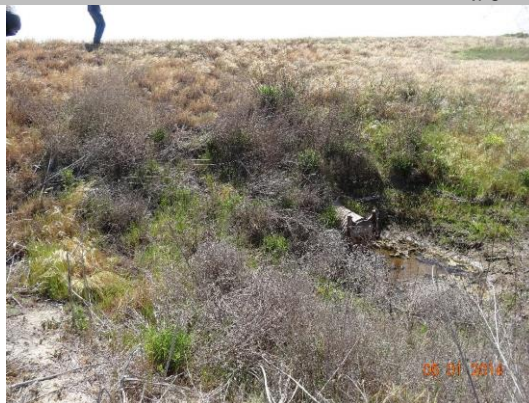
Photo 2 of 3 : UCIP\_SP\_2017\_39502\_67269.jpg

Comment Code					
Inspector Comment					
FS_ID:39502 DS_ID:19970 EP_NO: N/A Repair Type: Non-Urgent Crossing Status: Found UCIP Comments: Dense vegetation limits the inspectors visibility to identify signs of pipe failure (leaks) along the slope. Recommend removing vegetation along pipe alignment to conduct proper inspection of structure. Sediment buildup in pipe visible on landward side--recommend clearing. FIELD_STRUCT_DESC: 24-inch CM pipe through the levee, 11.2 feet below the crown. Flap gate on the waterward end. (USACE-1967). This entry matches the Drainage or Irrigation Structure referenced in O&M manual (HLM 2.45). FS Date: 5/1/2014 4:04:00 PM

Pipe daylights at waterward toe.

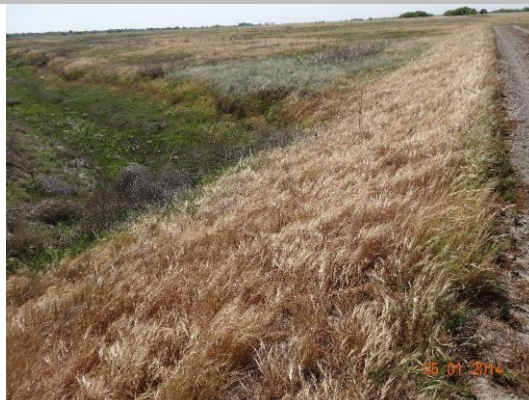
Photo 3 of 3 : UCIP\_SP\_2017\_39502\_67268.jpg

View of landward side.
