**Flood Control Project Maintenance  
Levee Inspections**  
**LMA District Cover Sheet**  
**Spring 2018 Levee Inspection Results**

**Lower San Joaquin Levee District**

**Spring 2018 Levee Inspection Results**

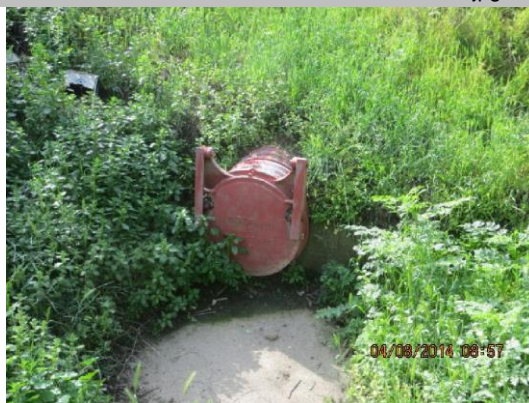
FS\_ID:39091  
DS\_ID:19650  
EP\_NO: N/A  
Repair Type: Non-Urgent  
Crossing Status: Found  
UCIP Comments: Dense vegetation limits the inspector's visibility to identify signs of pipe failure (leaks) along the waterward slope and landward toe. Recommend removing vegetation along pipe alignment and landward toe to conduct proper inspection of structure and appurtenances.  
FIELD\_STRUCT\_DESC: 24-inch corrugated metal gravity drainage pipe through the levee, 10.5 feet below the crown. Flap gate on the waterside (WS) end. Brass cap No. 108 bench mark (BM) on the headwall on the landside (LS), elevation 65.1 feet, USGS Datum.  
[Additional Reference(s): DWR Levee Log, 2002. USACE San Joaquin O&M Manual 601.1, 1967, (HLM 0.02)].  
FS Date: 4/8/2014 7:34:00 AM

Flapgate on WS toe.

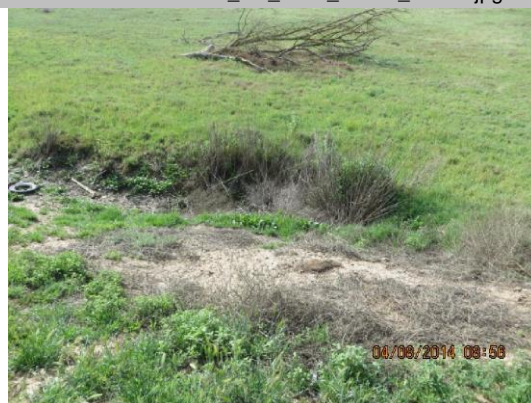
Photo 3 of 3 : UCIP\_SP\_2018\_39091\_60602.jpg

Comment Code						
Inspector Comment						
FS_ID:39091 DS_ID:19650 EP_NO: N/A Repair Type: Non-Urgent Crossing Status: Found UCIP Comments: Dense vegetation limits the inspector's visibility to identify signs of pipe failure (leaks) along the waterward slope and landward toe. Recommend removing vegetation along pipe alignment and landward toe to conduct proper inspection of structure and appurtenances. FIELD_STRUCT_DESC: 24-inch corrugated metal gravity drainage pipe through the levee, 10.5 feet below the crown. Flap gate on the waterside (WS) end. Brass cap No. 108 bench mark (BM) on the headwall on the landside (LS), elevation 65.1 feet, USGS Datum. [Additional Reference(s): DWR Levee Log, 2002. USACE San Joaquin O&M Manual 601.1, 1967, (HLM 0.02)]. FS Date: 4/8/2014 7:34:00 AM

Headwall on LS toe.

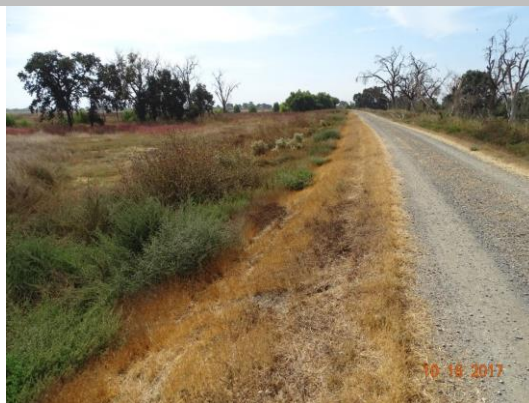
Photo 1 of 1 : SP\_2018\_NA0010\_118\_102\_20180307\_00018.jpg

LM Start	0.06	Rating **	A/W	Issue No.	102
LM End	0.27	Issue Type +	Ma	Location *	LS
Category	Earthen Levee			GPS Latitude/Longitude	
				Start	End
Item	Vegetation			37.348139 °	37.345556 °
				-120.959688 °	-120.961795 °
DWR ID	DWR_NA0010_01_f_2017_102				
Comment Code					
V2 : Remove the wild growth other than native grasses from the levee slopes.					
Inspector Comment					
Dense vegetation at the landside toe.

Looking southwest at the landside slope.

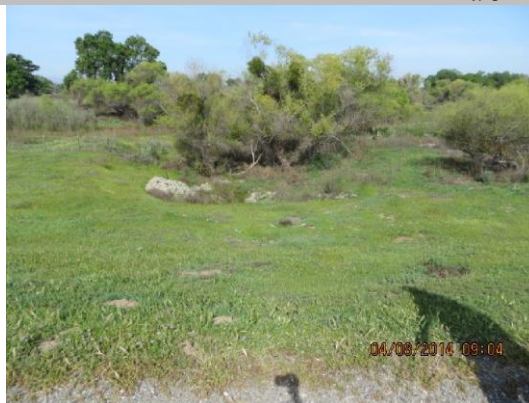
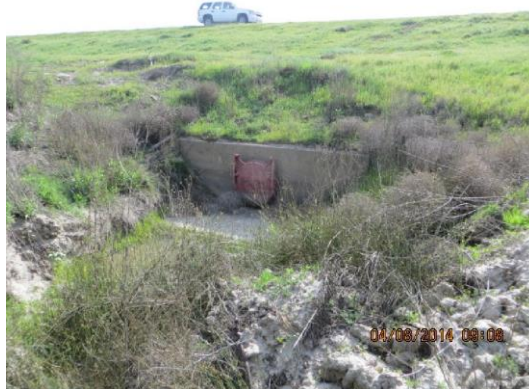
Comment Code						
Inspector Comment						
FS_ID:39092						
DS_ID:19651						
EP_NO: N/A						
Repair Type: Non-Urgent						
Crossing Status: Found						
UCIP Comments: Pipe has significant sediment buildup and shows some signs of corrosion at landward toe. Recommend cleaning sediment from inside pipe and check wall integrity.						
FIELD_STRUCT_DESC: 36-inch corrugated metal gravity drainage pipe through the levee, 18.5 feet below the crown. Flap gate on the waterside (WS) end. Brass cap No. 108 bench mark (BM) on the headwall on the landside (LS). [Additional Reference(s): DWR Levee Log, 2002. USACE San Joaquin O&M Manual 601.1, 1967, (HLM 0.35)].						
FS Date: 4/8/2014

Flapgate and headwall visible off WS toe.

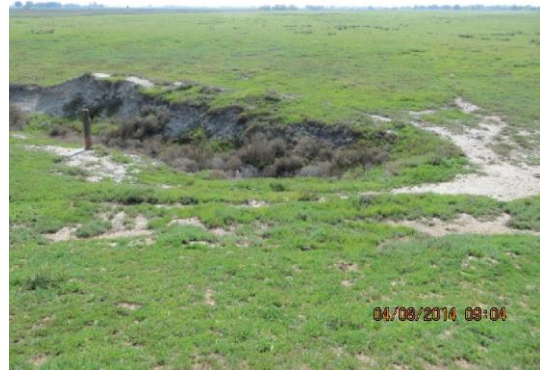
Photo 3 of 3 : UCIP\_SP\_2018\_39092\_60612.jpg

Comment Code						
Inspector Comment						
FS_ID:39092 DS_ID:19651 EP_NO: N/A Repair Type: Non-Urgent Crossing Status: Found UCIP Comments: Pipe has significant sediment buildup and shows some signs of corrosion at landward toe. Recommend cleaning sediment from inside pipe and check wall integrity. FIELD_STRUCT_DESC: 36-inch corrugated metal gravity drainage pipe through the levee, 18.5 feet below the crown. Flap gate on the waterside (WS) end. Brass cap No. 108 bench mark (BM) on the headwall on the landside (LS). [Additional Reference(s): DWR Levee Log, 2002. USACE San Joaquin O&M Manual 601.1, 1967, (HLM 0.35)]. FS Date: 4/8/2014

Pipe and headwall visible off LS toe.

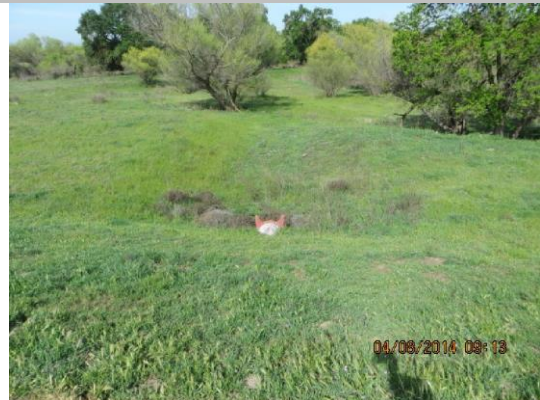
Photo 1 of 3 : UCIP\_SP\_2018\_39095\_60622.jpg

LM Start	0.60	Rating **	M	Issue No.	1187	
LM End	0.60	Issue Type +	Ma	Location *		
Category	Supplemental			GPS Latitude/Longitude		
				Start	End	
Item	DWR UCIP LMA Responsibility			37.341507 °	37.341507 °	
				-120.961283 °	-120.961283 °	
DWR ID						
Comment Code						
Inspector Comment						
FS_ID:39095 DS_ID:19583 EP_NO: N/A Repair Type: Non-Urgent Crossing Status: Found UCIP Comments: Recommend removing vegetation pile from waterward toe. FIELD_STRUCT_DESC: 24-inch corrugated metal gravity drainage pipe through the levee, 8.5 feet below the crown. Flap gate on the waterside (WS) end. Brass cap No. 108 bench mark (BM) on the headwall on the landside (LS). [Additional Reference(s): DWR Levee Log, 2002. USACE San Joaquin O&M Manual 601.1, 1967, (HLM 0.62)]. FS Date: 4/8/2014

Flapgate and headwall visible on WS toe.

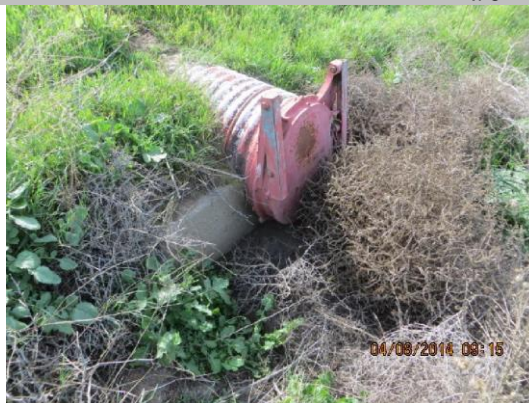
Photo 2 of 3 : UCIP\_SP\_2018\_39095\_60623.jpg

LM Start	0.60	Rating **	M	Issue No.	1187 (cont)	
LM End	0.60	Issue Type +	Ma	Location *		
Category	Supplemental			GPS Latitude/Longitude		
				Start	End	
Item	DWR UCIP LMA Responsibility			37.341507 °	37.341507 °	
				-120.961283 °	-120.961283 °	
DWR ID						
Comment Code						
Inspector Comment						
FS_ID:39095						
DS_ID:19583						
EP_NO: N/A						
Repair Type: Non-Urgent						
Crossing Status: Found						
UCIP Comments: Recommend removing vegetation pile from waterward toe.						
FIELD_STRUCT_DESC: 24-inch corrugated metal gravity drainage pipe through the levee, 8.5 feet below the crown. Flap gate on the waterside (WS) end. Brass cap No. 108 bench mark (BM) on the headwall on the landside (LS). [Additional Reference(s): DWR Levee Log, 2002. USACE San Joaquin O&M Manual 601.1, 1967, (HLM 0.62)].						
FS Date: 4/8/2014

Flapgate and headwall visible on WS toe.

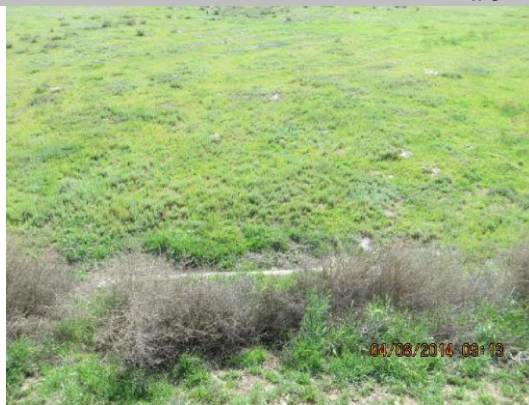
Photo 3 of 3 : UCIP\_SP\_2018\_39095\_60621.jpg

LM Start	<b>0.60</b>	Rating **	M	Issue No.	<b>1187 (cont)</b>
LM End	<b>0.60</b>	Issue Type +	Ma	Location *

Pipe and headwall visible on LS toe.

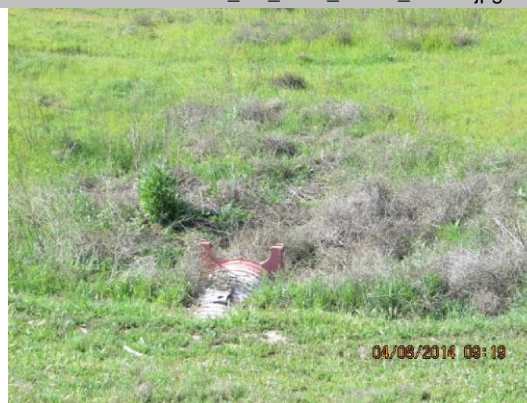
Photo 1 of 3 : UCIP\_SP\_2018\_33524\_60627.jpg

LM Start	0.85	Rating **	A/W	Issue No.	1188
LM End	0.85	Issue Type +	Ma	Location *	
Category	Supplemental			GPS Latitude/Longitude	
				Start	End
Item	DWR UCIP LMA Responsibility			37.339829 °	37.339829 °
				-120.958621 °	-120.958621 °
DWR ID					
Comment Code					
Inspector Comment					
FS_ID:33524					
DS_ID:19584					
EP_NO: N/A					
Repair Type: No Action Needed					
Crossing Status: Found					
UCIP Comments:					
FIELD_STRUCT_DESC: 24-inch corrugated metal gravity drainage pipe through the levee, 7 feet below the crown. Flap gate on the waterside (WS) end. Brass cap No. 108 bench mark (BM) on the headwall on the landside (LS). [Additional Reference(s): DWR Levee Log, 2002. USACE San Joaquin O&M Manual 601.1, 1967, (HLM 0.87)].					
FS Date: 4/8/2014

Pipe, flapgate, and headwall visible on WS toe.

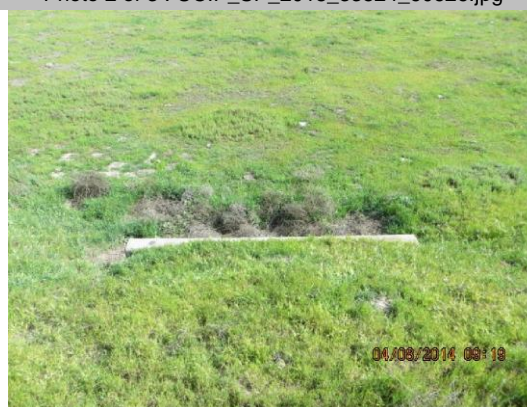
Photo 2 of 3 : UCIP\_SP\_2018\_33524\_60626.jpg

LM Start	<b>0.85</b>	Rating **	A/W	Issue No.	<b>1188 (cont)</b>
LM End	<b>0.85</b>	Issue Type +	Ma	Location *

Pipe and headwall visible on LS toe.

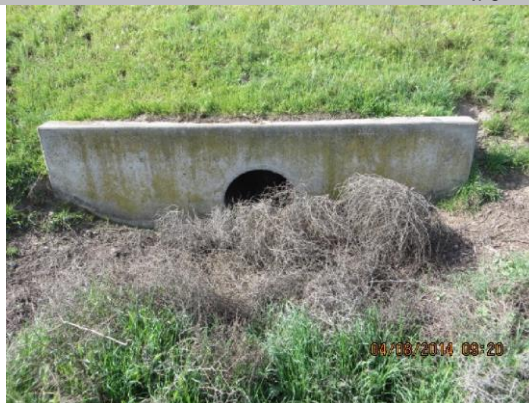
Photo 3 of 3 : UCIP\_SP\_2018\_33524\_60625.jpg

LM Start	0.85	Rating **	A/W	Issue No.	1188 (cont)	
LM End	0.85	Issue Type +	Ma	Location *		
Category	Supplemental			GPS Latitude/Longitude		
				Start	End	
Item	DWR UCIP LMA Responsibility			37.339829 °	37.339829 °	
				-120.958621 °	-120.958621 °	
DWR ID						
Comment Code						
Inspector Comment						
FS_ID:33524						
DS_ID:19584						
EP_NO: N/A						
Repair Type: No Action Needed						
Crossing Status: Found						
UCIP Comments:						
FIELD_STRUCT_DESC: 24-inch corrugated metal gravity drainage pipe						
through the levee, 7 feet below the crown. Flap gate on the waterside						
(WS) end. Brass cap No. 108 bench mark (BM) on the headwall on the						
landside (LS). [Additional Reference(s): DWR Levee Log, 2002. USACE						
San Joaquin O&M Manual 601.1, 1967, (HLM 0.87)].						
FS Date: 4/8/2014

Pipe and headwall visible on LS toe.

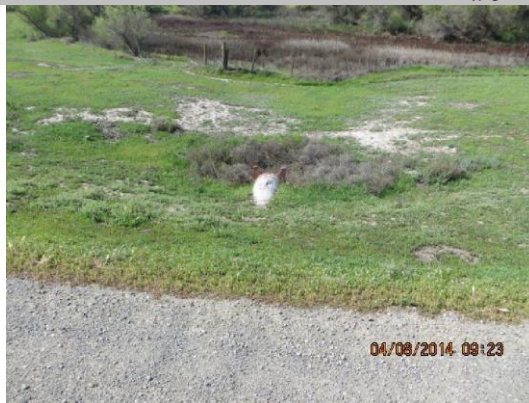
Photo 1 of 3 : UCIP\_SP\_2018\_39096\_60632.jpg

Comment Code						
Inspector Comment						
FS_ID:39096 DS_ID:19585 EP_NO: N/A Repair Type: Non-Urgent Crossing Status: Found UCIP Comments: Moderate erosion around headwall on landward toe. May or may not be an issue. Need to contact owner to determine status of crossing and to address erosion issue on landward side. FIELD_STRUCT_DESC: 24-inch corrugated metal gravity drainage pipe through the levee, 7 feet below the crown. Flap gate on the waterside (WS) end. Brass cap No. 108 bench mark (BM) on the headwall on the landside (LS). [Additional Reference(s): DWR Levee Log, 2002. USACE San Joaquin O&M Manual 601.1, 1967, (HLM 0.95)]. FS Date: 4/8/2014

Flapgate, pipe, and headwall on WS toe.

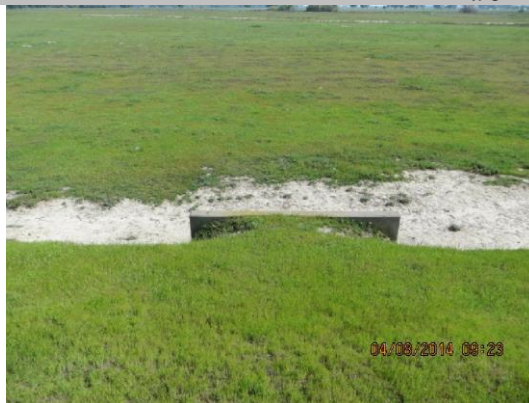
Photo 2 of 3 : UCIP\_SP\_2018\_39096\_60631.jpg

Comment Code						
Inspector Comment						
FS_ID:39096						
DS_ID:19585						
EP_NO: N/A						
Repair Type: Non-Urgent						
Crossing Status: Found						
UCIP Comments: Moderate erosion around headwall on landward toe.						
May or may not be an issue. Need to contact owner to determine status						
of crossing and to address erosion issue on landward side.						
FIELD_STRUCT_DESC: 24-inch corrugated metal gravity drainage pipe						
through the levee, 7 feet below the crown. Flap gate on the waterside						
(WS) end. Brass cap No. 108 bench mark (BM) on the headwall on the						
landside (LS). [Additional Reference(s): DWR Levee Log, 2002. USACE						
San Joaquin O&M Manual 601.1, 1967, (HLM 0.95)].						
FS Date: 4/8/2014

Concrete headwall and pipe visible at LS toe.

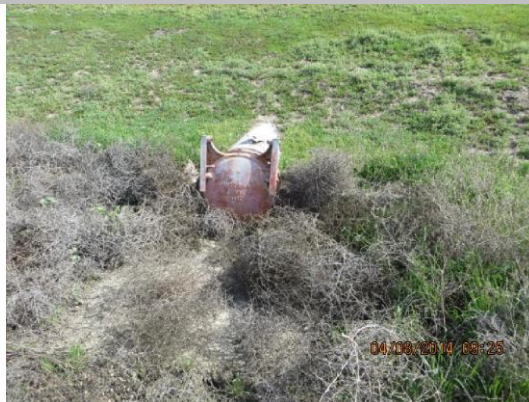
Photo 3 of 3 : UCIP\_SP\_2018\_39096\_60633.jpg

Flapgate, pipe, and headwall on WS toe.

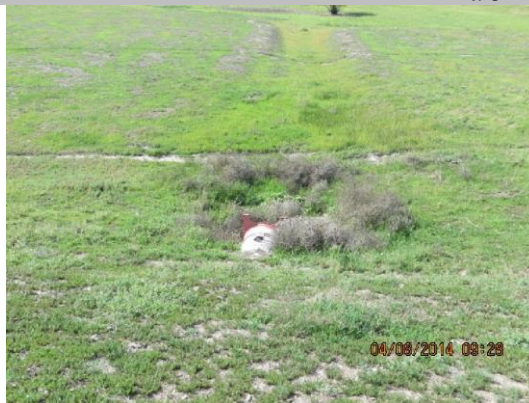
Photo 1 of 3 : UCIP\_SP\_2018\_33543\_60642.jpg

LM Start	1.15	Rating **	A/W	Issue No.	1190	
LM End	1.15	Issue Type +	Ma	Location *		
Category	Supplemental			GPS Latitude/Longitude		
				Start	End	
Item	DWR UCIP LMA Responsibility			37.338005 °	37.338005 °	
				-120.953921 °	-120.953921 °	
DWR ID						
Comment Code						
Inspector Comment						
FS_ID:33543						
DS_ID:19586						
EP_NO: N/A						
Repair Type: No Action Needed						
Crossing Status: Found						
UCIP Comments:						
FIELD_STRUCT_DESC: 24-inch corrugated metal gravity drainage pipe through the levee, 7.5 feet below the crown. Flap gate on the waterside (WS) end. Brass cap No. 108 bench mark (BM) on the headwall on the landside (LS). [Additional Reference(s): DWR Levee Log, 2002. USACE San Joaquin O&M Manual 601.1, 1967, (HLM 1.17)].						
FS Date: 4/8/2014

Pipe, headwall, and flapgate visible on WS toe.

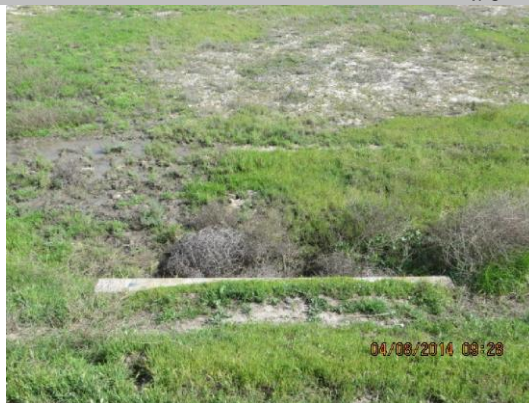
Photo 3 of 3 : UCIP\_SP\_2018\_33543\_60641.jpg

LM Start	1.15	Rating **	A/W	Issue No.	1190 (cont)	
LM End	1.15	Issue Type +	Ma	Location *		
Category	Supplemental			GPS Latitude/Longitude		
				Start	End	
Item	DWR UCIP LMA Responsibility			37.338005 °	37.338005 °	
				-120.953921 °	-120.953921 °	
DWR ID						
Comment Code						
Inspector Comment						
FS_ID:33543						
DS_ID:19586						
EP_NO: N/A						
Repair Type: No Action Needed						
Crossing Status: Found						
UCIP Comments:						
FIELD_STRUCT_DESC: 24-inch corrugated metal gravity drainage pipe						
through the levee, 7.5 feet below the crown. Flap gate on the waterside						
(WS) end. Brass cap No. 108 bench mark (BM) on the headwall on the						
landside (LS). [Additional Reference(s): DWR Levee Log, 2002. USACE						
San Joaquin O&M Manual 601.1, 1967, (HLM 1.17)].						
FS Date: 4/8/2014

Headwall and pipe visible on LS toe.

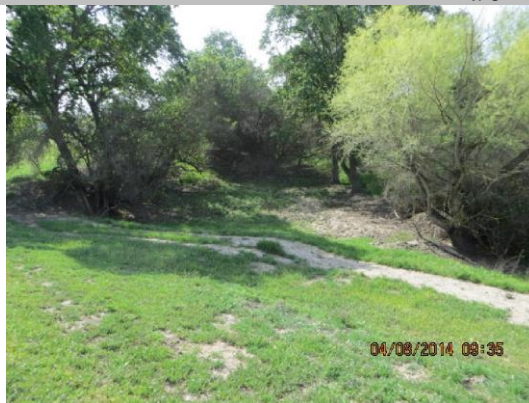
Photo 1 of 3 : UCIP\_SP\_2018\_33544\_60649.jpg

LM Start	1.32	Rating **	A/W	Issue No.	1191
LM End	1.32	Issue Type +	Ma	Location *	
Category	Supplemental			GPS Latitude/Longitude	
				Start	End
Item	DWR UCIP LMA Responsibility			37.337361 °	37.337361 °
				-120.950879 °	-120.950879 °
DWR ID					
Comment Code					
Inspector Comment					
FS_ID:33544 DS_ID:19587 EP_NO: N/A Repair Type: No Action Needed Crossing Status: Found UCIP Comments: FIELD_STRUCT_DESC: 36-inch corrugated metal gravity drainage pipe through the levee, 12.8 feet below the crown. Flap gate on the waterside (WS) end. Brass cap No. 108 bench mark (BM) on the headwall on the landside (LS). Pipe crosses through the levee at about a 45 degree angle to the crown. [Additional Reference(s): DWR Levee Log, 2002. USACE San Joaquin O&M Manual 601.1, 1967, (HLM 1.34)]. FS Date: 4/8/2014

Concrete headwall and flapgate visible at WS toe.

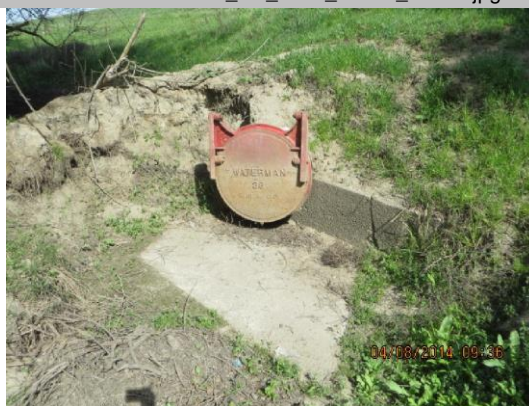
Photo 2 of 3 : UCIP\_SP\_2018\_33544\_60648.jpg

LM Start	1.32	Rating **	A/W	Issue No.	1191 (cont)	
LM End	1.32	Issue Type +	Ma	Location *		
Category	Supplemental			GPS Latitude/Longitude		
				Start	End	
Item	DWR UCIP LMA Responsibility			37.337361 °	37.337361 °	
				-120.950879 °	-120.950879 °	
DWR ID						
Comment Code						
Inspector Comment						
FS_ID:33544						
DS_ID:19587						
EP_NO: N/A						
Repair Type: No Action Needed						
Crossing Status: Found						
UCIP Comments:						
FIELD_STRUCT_DESC: 36-inch corrugated metal gravity drainage pipe through the levee, 12.8 feet below the crown. Flap gate on the waterside (WS) end. Brass cap No. 108 bench mark (BM) on the headwall on the landside (LS). Pipe crosses through the levee at about a 45 degree angle to the crown. [Additional Reference(s): DWR Levee Log, 2002. USACE San Joaquin O&M Manual 601.1, 1967, (HLM 1.34)].						
FS Date: 4/8/2014

Concrete headwall and flapgate visible at WS toe.

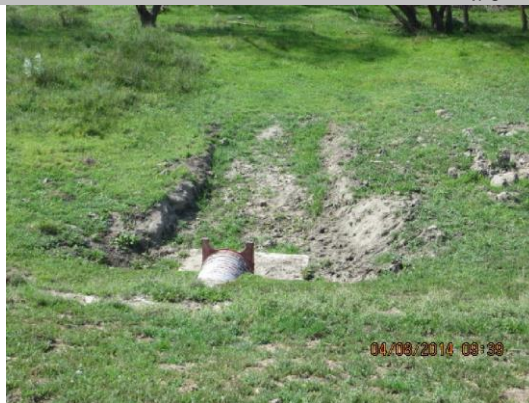
Photo 1 of 3 : UCIP\_SP\_2018\_39099\_60652.jpg

Comment Code						
Inspector Comment						
FS_ID:39099						
DS_ID:19588						
EP_NO: N/A						
Repair Type: Non-Urgent						
Crossing Status: Found						
UCIP Comments: Some sediment buildup inside pipe at LS toe.						
Recommend contacting owner to clear sediment buildup and check wall integrity through pipe section.						
FIELD_STRUCT_DESC: 24-inch corrugated metal gravity drainage pipe through the levee, 11 feet below the crown. Flap gate on the waterside (WS) end. Brass cap No. 108 bench mark (BM) on the headwall on the landside (LS). [Additional Reference(s): DWR Levee Log, 2002. USACE San Joaquin O&M Manual 601.1, 1967, (HLM 1.48)].						
FS Date: 4/8/2014

Pipe, flapgate, and concrete headwall visible on WS toe.

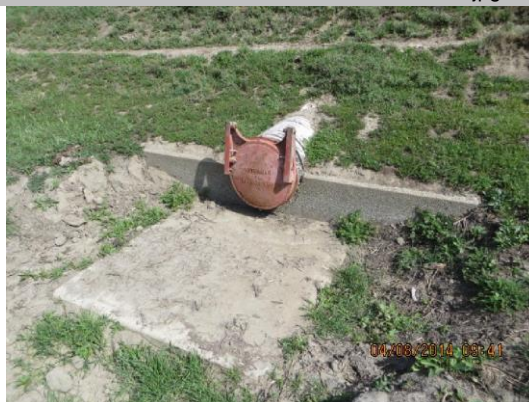
Photo 2 of 3 : UCIP\_SP\_2018\_39099\_60653.jpg

Pipe, flapgate, and concrete headwall visible on WS toe.

Comment Code						
Inspector Comment						
FS_ID:39099						
DS_ID:19588						
EP_NO: N/A						
Repair Type: Non-Urgent						
Crossing Status: Found						
UCIP Comments: Some sediment buildup inside pipe at LS toe.						
Recommend contacting owner to clear sediment buildup and check wall integrity through pipe section.						
FIELD_STRUCT_DESC: 24-inch corrugated metal gravity drainage pipe through the levee, 11 feet below the crown. Flap gate on the waterside (WS) end. Brass cap No. 108 bench mark (BM) on the headwall on the landside (LS). [Additional Reference(s): DWR Levee Log, 2002. USACE San Joaquin O&M Manual 601.1, 1967, (HLM 1.48)].						
FS Date: 4/8/2014

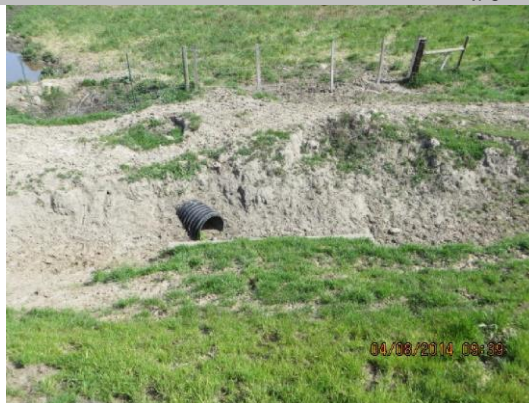
Photo 3 of 3 : UCIP\_SP\_2018\_39099\_60651.jpg

Pipe and concrete headwall visible on LS toe.

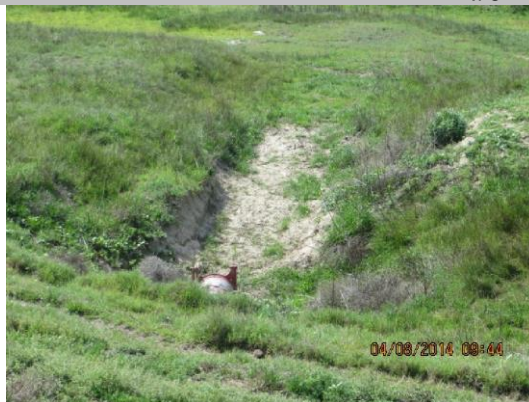
Photo 1 of 3 : UCIP\_SP\_2018\_33563\_60661.jpg

Pipe, headwall, and flapgate visible on WS toe.

FS\_ID:33563  
DS\_ID:19589  
EP\_NO: N/A  
Repair Type: Non-Urgent  
Crossing Status: Found  
UCIP Comments: Heavy sediment buildup in pipe at LS toe.  
FIELD\_STRUCT\_DESC: 24-inch corrugated metal gravity drainage pipe through the levee, 13.6 feet below the crown. Flap gate on the waterside (WS) end. Brass cap No. 108 bench mark (BM) on the headwall on the landside (LS). [Additional Reference(s): DWR Levee Log, 2002. USACE San Joaquin O&M Manual 601.1, 1967, (HLM 1.69)].  
FS Date: 4/8/2014

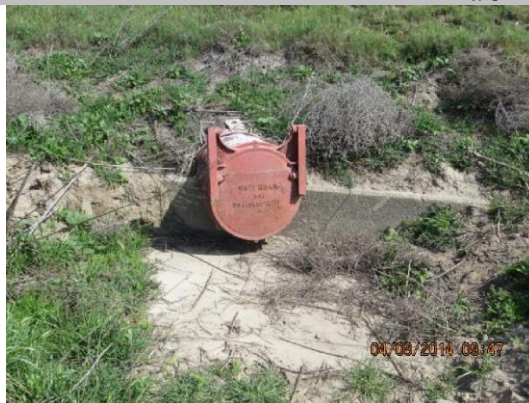
Photo 2 of 3 : UCIP\_SP\_2018\_33563\_60663.jpg

Pipe, headwall, and flapgate visible on WS toe.

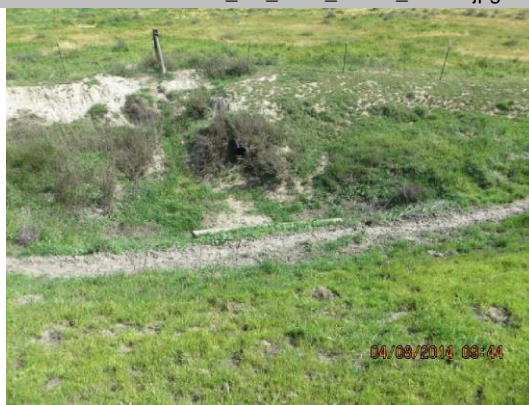
Photo 3 of 3 : UCIP\_SP\_2018\_33563\_60662.jpg

Pipe and headwall visible on LS toe.

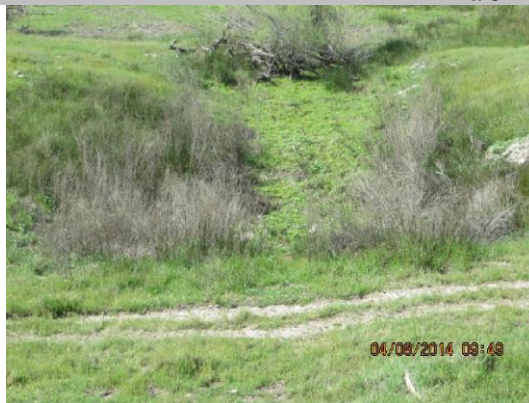
Photo 1 of 3 : UCIP\_SP\_2018\_33564\_60666.jpg

Pipe, flapgate, and headwall visible at WS toe.

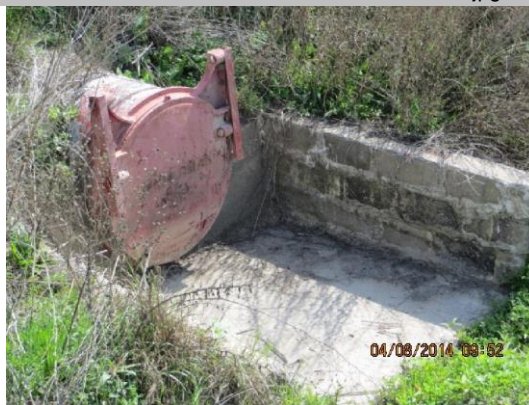
Photo 2 of 3 : UCIP\_SP\_2018\_33564\_60667.jpg

Pipe, flapgate, and headwall visible at WS toe.

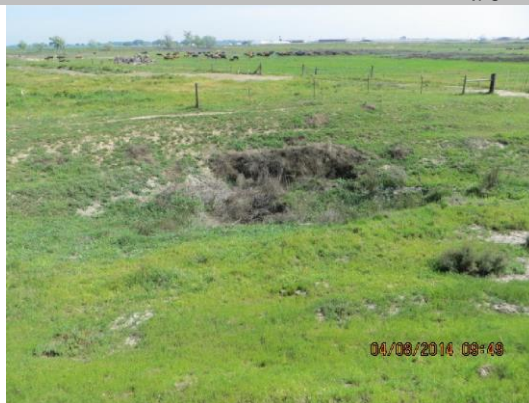
Photo 3 of 3 : UCIP\_SP\_2018\_33564\_60665.jpg

Pipe and concrete headwall visible at LS toe.

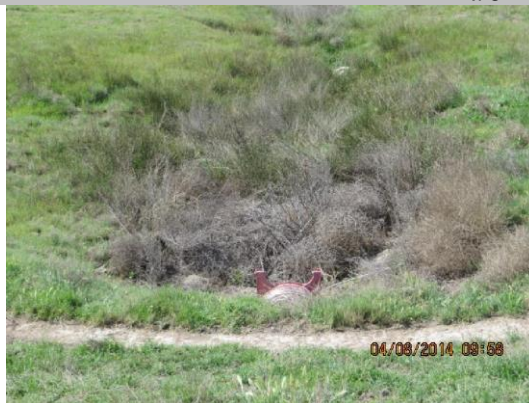
Photo 1 of 3 : UCIP\_SP\_2018\_39100\_60670.jpg

Comment Code						
Inspector Comment						
FS_ID:39100						
DS_ID:19591						
EP_NO: N/A						
Repair Type: Non-Urgent						
Crossing Status: Found						
UCIP Comments: Need to contact owner to determine crossing status.						
Inlet drop box silted in and needs to be cleaned out.						
FIELD_STRUCT_DESC: 24-inch corrugated metal gravity drainage pipe						
through the levee, 9.7 feet below the crown. Flap gate on the waterside						
(WS) end. Brass cap No. 100 bench mark (BM) on the headwall on the						
landside (LS). Wooden barrier around drop inlet on the LS toe.						
[Additional Reference(s): DWR Levee Log, 2002. USACE San Joaquin						
O&M Manual 601.1, 1967, (HLM 1.98)].						
FS Date: 4/8/2014

Concrete headwall and flapgate on WS toe.

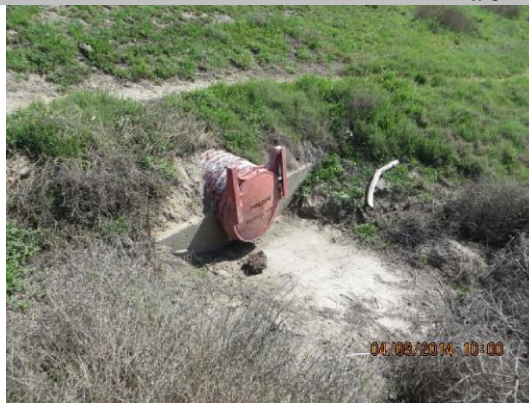
Photo 2 of 3 : UCIP\_SP\_2018\_39100\_60672.jpg

Comment Code						
Inspector Comment						
FS_ID:39100						
DS_ID:19591						
EP_NO: N/A						
Repair Type: Non-Urgent						
Crossing Status: Found						
UCIP Comments: Need to contact owner to determine crossing status.						
Inlet drop box silted in and needs to be cleaned out.						
FIELD_STRUCT_DESC: 24-inch corrugated metal gravity drainage pipe						
through the levee, 9.7 feet below the crown. Flap gate on the waterside						
(WS) end. Brass cap No. 100 bench mark (BM) on the headwall on the						
landside (LS). Wooden barrier around drop inlet on the LS toe.						
[Additional Reference(s): DWR Levee Log, 2002. USACE San Joaquin						
O&M Manual 601.1, 1967, (HLM 1.98)].						
FS Date: 4/8/2014

Pipe, flapgate, and headwall on WS toe.

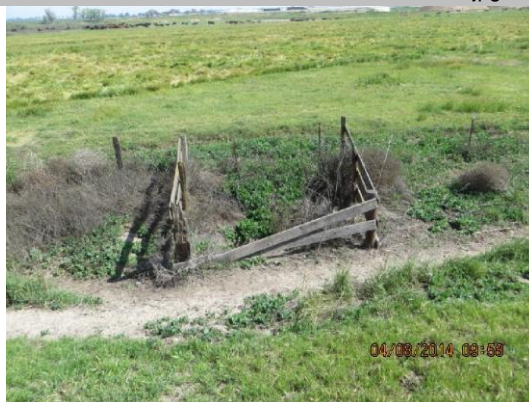
Photo 3 of 3 : UCIP\_SP\_2018\_39100\_60671.jpg

Wooded barrier around drop-inlet on LS toe.

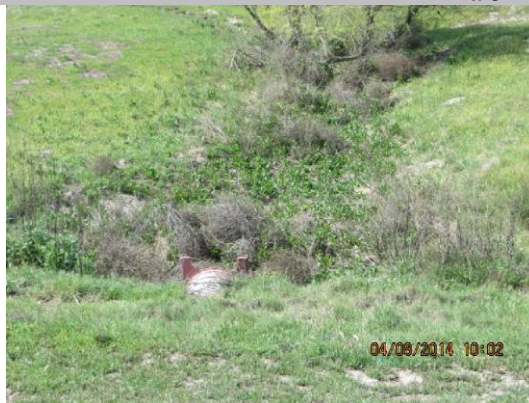
Photo 1 of 3 : UCIP\_SP\_2018\_39123\_60675.jpg

Pipe and flapgate visible on WS toe.

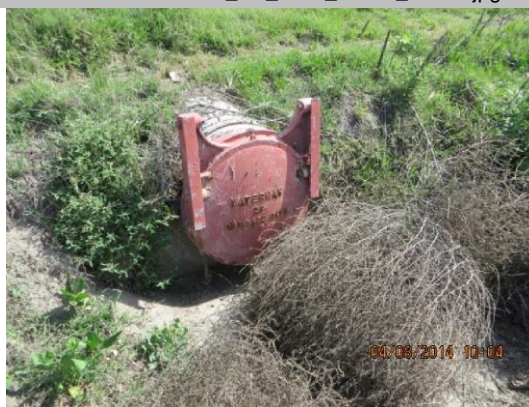
Photo 2 of 3 : UCIP\_SP\_2018\_39123\_60676.jpg

Pipe and flapgate visible on WS toe.

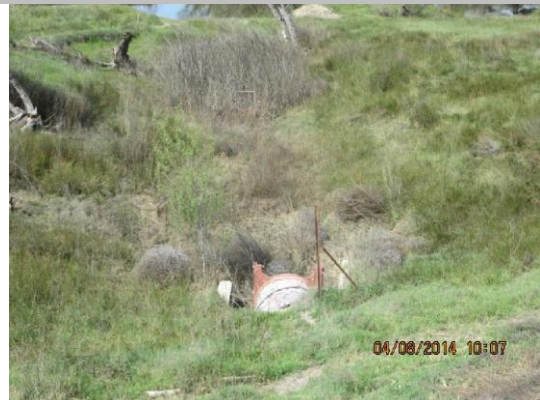
Photo 1 of 3 : UCIP\_SP\_2018\_39125\_71309.jpg

Pipe and flapgate on WS toe.

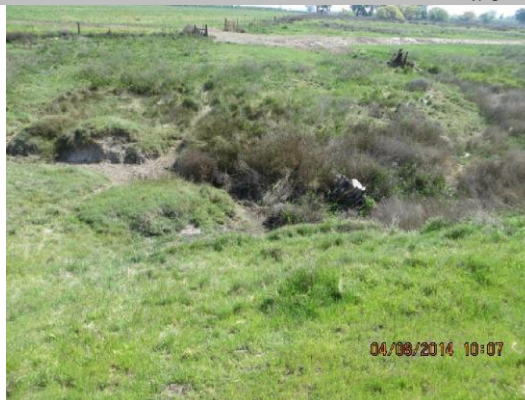
Photo 2 of 3 : UCIP\_SP\_2018\_39125\_71308.jpg

Pipe and headwall on LS toe.

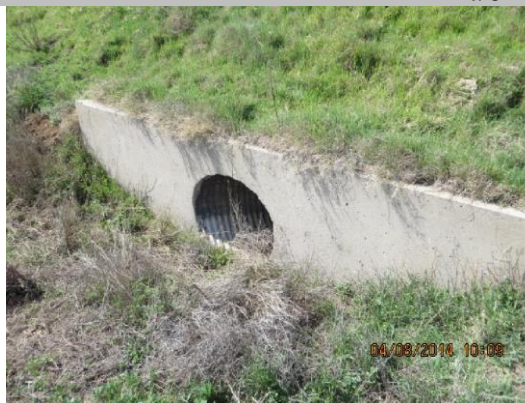
Photo 3 of 3 : UCIP\_SP\_2018\_39125\_71307.jpg

Pipe and headwall on LS toe.

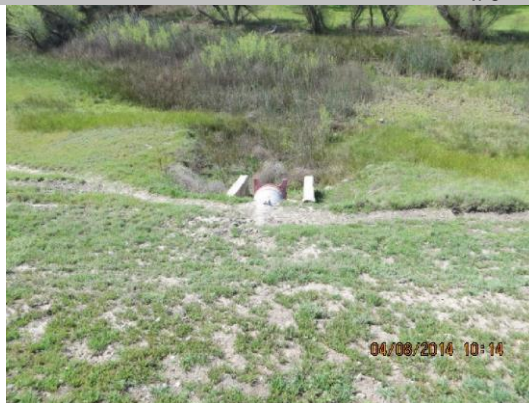
Photo 1 of 3 : UCIP\_SP\_2018\_33568\_60679.jpg

Pipe, headwall, and flapgate on WS toe.

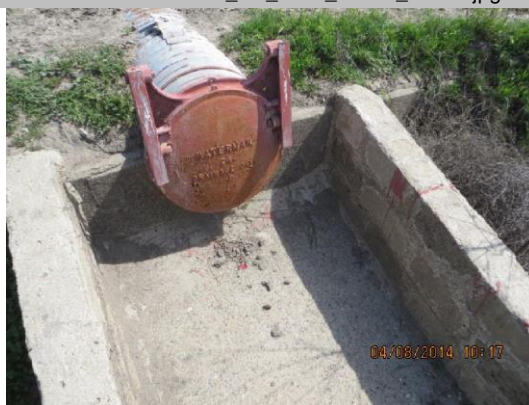
Photo 2 of 3 : UCIP\_SP\_2018\_33568\_60680.jpg

Pipe, headwall, and flapgate on WS toe.

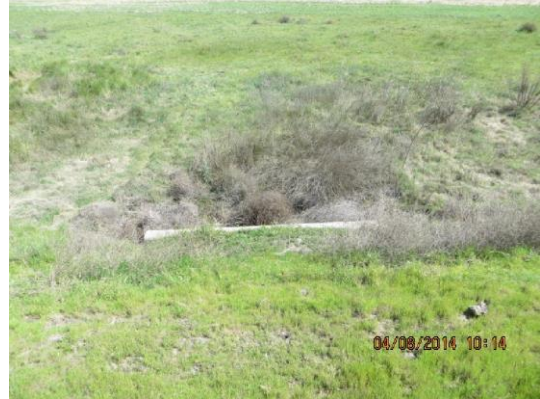
Photo 3 of 3 : UCIP\_SP\_2018\_33568\_60678.jpg

Pipe and headwall on LS toe.

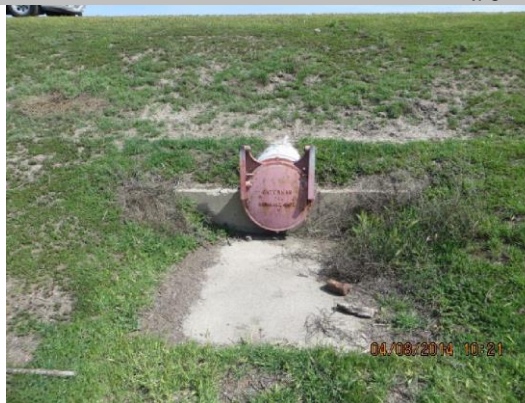
Photo 2 of 3 : UCIP\_SP\_2018\_39127\_60689.jpg

Pipe, flapgate, and headwall on WS toe.

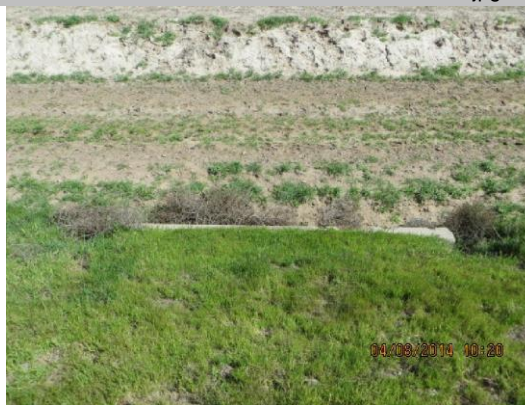
Photo 3 of 3 : UCIP\_SP\_2018\_39127\_60687.jpg

Pipe and headwall on LS toe.

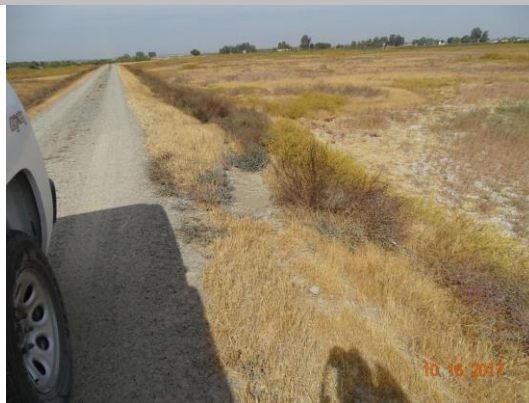
Photo 1 of 1 : SP\_2018\_NA0010\_118\_104\_20180307\_00019.jpg

LM Start	3.06	Rating **	M	Issue No.	104
LM End	3.06	Issue Type +	Ma	Location *	LS
Category	Earthen Levee			GPS Latitude/Longitude	
				Start	End
Item	Slope Stability			37.322499 °	37.322499 °
				-120.928986 °	-120.928986 °
DWR ID	DWR_NA0010_01_f_2017_104				
Comment Code					
S2 : Repair the levee slope damaged by foot traffic and prevent access where possible.					
Inspector Comment					
Slope damage caused by foot traffic.

Looking northeast at the landside slope.

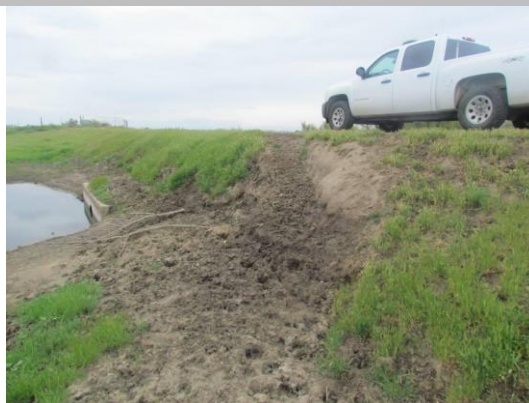
Photo 1 of 1 : SP\_2018\_NA0010\_118\_108\_20180307\_00020.jpg

LM Start	3.13	Rating **	M	Issue No.	108
LM End	3.13	Issue Type +	Ma	Location *	LS
Category	Earthen Levee			GPS Latitude/Longitude	
				Start	End
Item	Slope Stability			37.321468 °	37.321468 °
				-120.928757 °	-120.928757 °
DWR ID	DWR_NA0010_01_s_2017_108				
Comment Code					
S2 : Repair the levee slope damaged by foot traffic and prevent access where possible.					
Inspector Comment					
Slope damage caused by animal traffic on landside toe.

Looking west at slope damage caused by animal traffic.

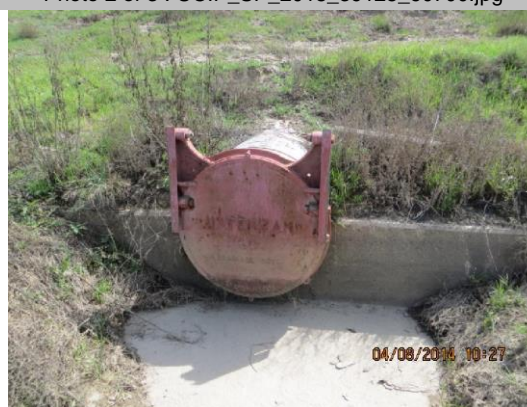
Photo 2 of 3 : UCIP\_SP\_2018\_39128\_60700.jpg

Pipe, Flapgate, and headwall on WS toe.

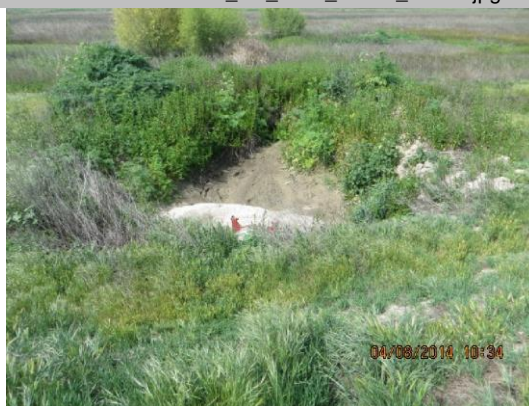
Photo 1 of 3 : UCIP\_SP\_2018\_50054\_60707.jpg

Comment Code					
Inspector Comment					
FS_ID:50054 DS_ID:19575 EP_NO: N/A Repair Type: Urgent Crossing Status: Found UCIP Comments: 7/19/2016 Same as previous inspection. Erosion present on LS slope. (DWR UCIP - omagana)4/08/2014 Pipe rusted through at Springline on LS toe. Flapgate blocked by sediment on WS toe. Heavy sediment on both ends of pipe. Need to contact owner to address issues. (DWR UCIP - omagana) FIELD_STRUCT_DESC: 36-inch corrugated metal gravity drainage pipe through the levee, 9.7 feet below the crown. Flap gate on the waterside (WS) end. Brass cap No. 100 bench mark (BM) on the headwall on the landside (LS). [Additional Reference(s): DWR Levee Log, 2002. USACE San Joaquin O&M Manual 601.1, 1967, (HLM 3.50)]. FS Date: 7/19/2016

Pipe, headwall, and flapgate on WS toe.

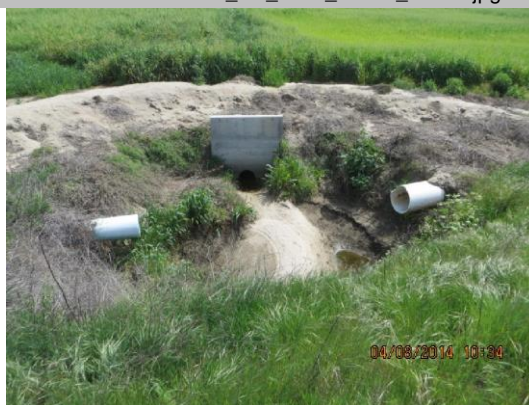
Photo 2 of 3 : UCIP\_SP\_2018\_50054\_60706.jpg

Pipe and headwall on LS toe.

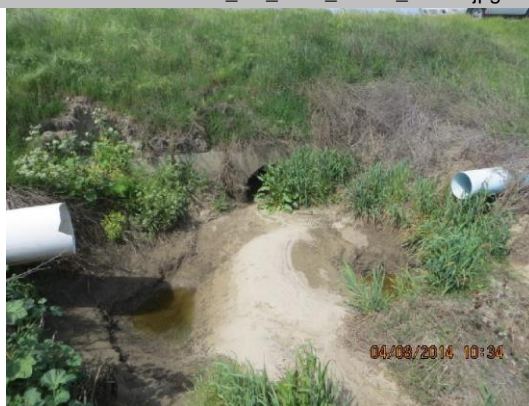
Photo 3 of 3 : UCIP\_SP\_2018\_50054\_60705.jpg

Comment Code						
Inspector Comment						
FS_ID:50054 DS_ID:19575 EP_NO: N/A Repair Type: Urgent Crossing Status: Found UCIP Comments: 7/19/2016 Same as previous inspection. Erosion present on LS slope. (DWR UCIP - omagana)4/08/2014 Pipe rusted through at Springline on LS toe. Flapgate blocked by sediment on WS toe. Heavy sediment on both ends of pipe. Need to contact owner to address issues. (DWR UCIP - omagana) FIELD_STRUCT_DESC: 36-inch corrugated metal gravity drainage pipe through the levee, 9.7 feet below the crown. Flap gate on the waterside (WS) end. Brass cap No. 100 bench mark (BM) on the headwall on the landside (LS). [Additional Reference(s): DWR Levee Log, 2002. USACE San Joaquin O&M Manual 601.1, 1967, (HLM 3.50)]. FS Date: 7/19/2016

Pipe and headwall on LS toe.

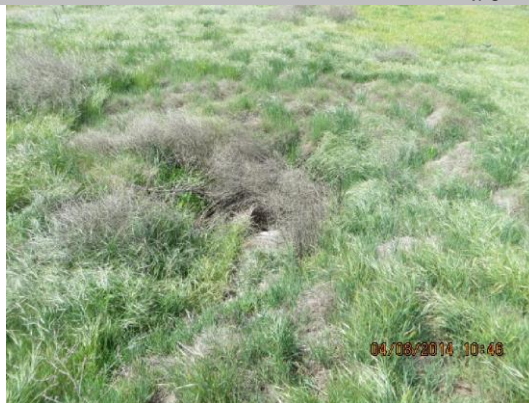
Photo 1 of 3 : UCIP\_SP\_2018\_39132\_60723.jpg

FS\_ID:39132  
DS\_ID:19576  
EP\_NO: N/A  
Repair Type: Non-Urgent  
Crossing Status: Found  
UCIP Comments: Slide gate missing from WS. No closure device, but degrading of levee at Highway 140 is lower than pipe, so this does not appear to be a critical issue. Also dense vegetation limits the inspector's visibility to identify signs of pipe failure (leaks) along the slope. Recommend removing vegetation along pipe alignment to conduct proper inspection of structure and appurtenances.  
FIELD\_STRUCT\_DESC: 30-inch corrugated metal gravity drainage pipe through the levee, 3.5 feet below the crown. Flap gate on the waterside (WS) end. Brass cap No. 100 bench mark (BM) on the headwall on the landside (LS). [Additional Reference(s): DWR Levee Log, 2002. USACE San Joaquin O&M Manual 601.1, 1967, (HLM 3.95)].  
FS Date: 4/8/2014

Slide gate missing on WS toe with heavy vegetation camouflaging pipe

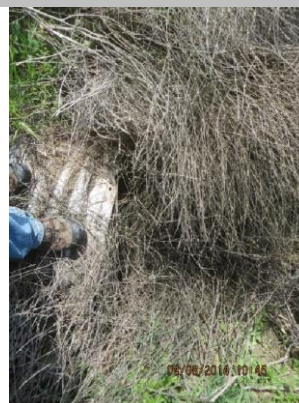
Photo 2 of 3 : UCIP\_SP\_2018\_39132\_60720.jpg

Slide gate missing on WS toe with heavy vegetation camouflaging pipe

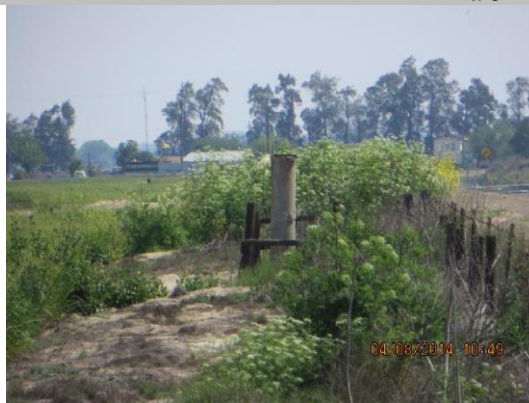
Photo 2 of 2 : UCIP\_SP\_2018\_39133\_60724.jpg

LM Start	3.93	Rating **	M	Issue No.	1203 (cont)	
LM End	3.93	Issue Type +	En	Location *		
Category	Supplemental			GPS Latitude/Longitude		
				Start	End	
Item	DWR UCIP Field Study			37.311157°	37.311157°	
				-120.926919°	-120.926919°	
DWR ID						
Comment Code						
Inspector Comment						
FS_ID:39133						
DS_ID:19606						
EP_NO: N/A						
Repair Type: Non-Urgent						
Crossing Status: Indicator Found						
UCIP Comments: Need to contact owner to determine status of crossing inlet and outlet not found.						
FIELD_STRUCT_DESC: 12-inch reinforced concrete irrigation discharge pipe through the levee, 3.5 feet below the crown. 12-inch concrete standpipe off each side of the levee. [Additional Reference(s): FS Levee Log, 2002].						
FS Date: 4/8/2014

12-inch concrete standpipe off LS toe.

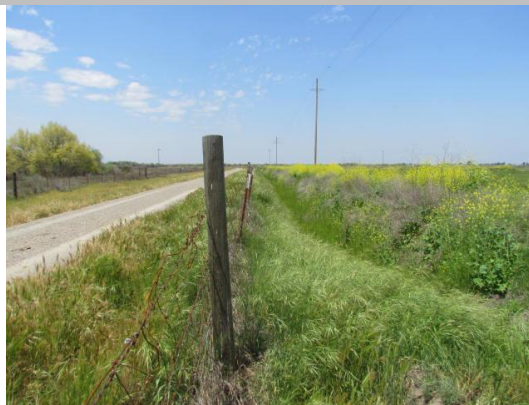
Photo 1 of 2 : SP\_2018\_NA0010\_118\_5\_20180307\_00002.jpg

LM Start	3.98	Rating **	U	Issue No.	5
LM End	4.05	Issue Type +	En	Location *	LS
Category	Earthen Levee			GPS Latitude/Longitude	
				Start	End
Item	Encroachments			37.310837 °	37.310003 °
				-120.926182 °	-120.925313 °
DWR ID	DWR_NA0010_01_s_2012_5				
Comment Code					
DT : Ditch					
Inspector Comment					
Irrigation ditch at landside toe

Looking north at irrigation ditch at landside toe.

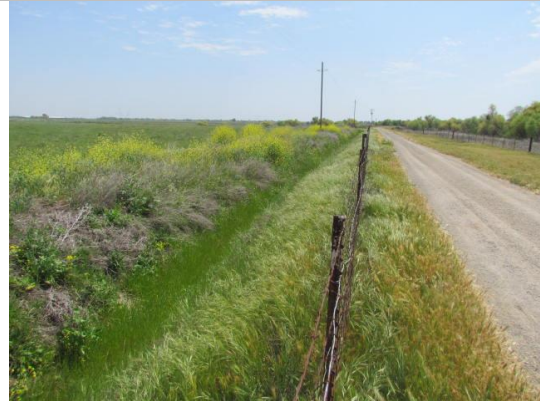
Photo 2 of 2 : SP\_2018\_NA0010\_118\_5\_20180307\_00003.jpg

LM Start	3.98	Rating **	U	Issue No.	5 (cont)	
LM End	4.05	Issue Type +	En	Location *	LS	
Category	Earthen Levee			GPS Latitude/Longitude		
				Start		End
Item	Encroachments			37.310837 °		37.310003 °
				-120.926182 °		-120.925313 °
DWR ID	DWR_NA0010_01_s_2012_5					
Comment Code						
DT : Ditch						
Inspector Comment						
Irrigation ditch at landside toe

Looking south at irrigation ditch at landside toe.

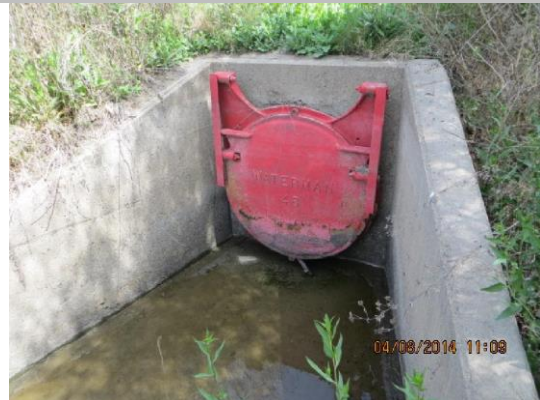
Photo 1 of 3 : UCIP\_SP\_2018\_39134\_60730.jpg

Comment Code						
Inspector Comment						
FS_ID:39134 DS_ID:19607 EP_NO: N/A Repair Type: Non-Urgent Crossing Status: Found UCIP Comments: Pipe appears sleeved with a 12-inch steel pipe with a slide gate at the LS toe. No identified authorization for changes to this crossing. Need to contact owner to obtain additional information about the modifications to crossing. FIELD_STRUCT_DESC: 48-inch corrugated metal gravity drainage pipe through the levee, 14 feet below the crown. Flap gate on the waterside (WS) end. Brass cap No. 90 bench mark (BM) on the headwall on the landside (LS). [Additional Reference(s): DWR Levee Log, 2002. USACE San Joaquin O&M Manual 601.1, 1967, (HLM 4.16)]. FS Date: 4/8/2014

Concrete headwall and 48-inch flapgate visible on WS toe.

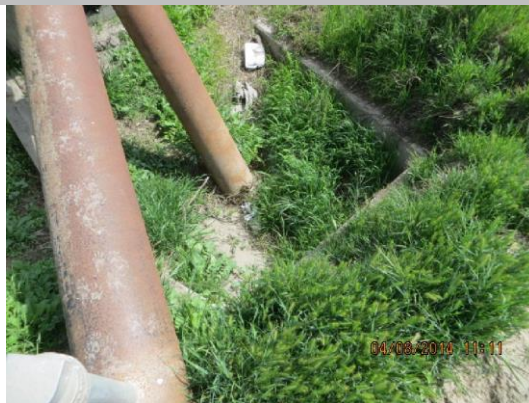
Photo 2 of 2 : UCIP\_SP\_2018\_39138\_71319.jpg

Pipe through existing 48 inch pipe.

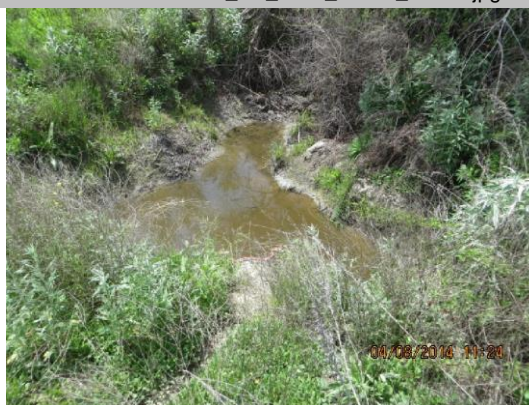
Photo 1 of 3 : UCIP\_SP\_2018\_39140\_60733.jpg

Comment Code					
Inspector Comment					
FS_ID:39140 DS_ID:19608 EP_NO: N/A Repair Type: Non-Urgent Crossing Status: Found UCIP Comments: Dense vegetation and fence limits the inspector's visibility to identify signs of pipe failure (leaks) along the landward side. Recommend obtaining access to landward toe and removing vegetation along pipe alignment to conduct proper inspection of structure and appurtenances. FIELD_STRUCT_DESC: 24-inch corrugated metal gravity drainage pipe through the levee, 11.9 feet below the crown. Flap gate on the waterside (WS) end. Brass cap No. 90 bench mark (BM) on the headwall on the landside (LS). [Additional Reference(s): DWR Levee Log, 2002. USACE San Joaquin O&M Manual 601.1, 1967, (HLM 4.27)]. FS Date: 4/8/2014

Pipe, flapgate, and headwall visible at WS toe.

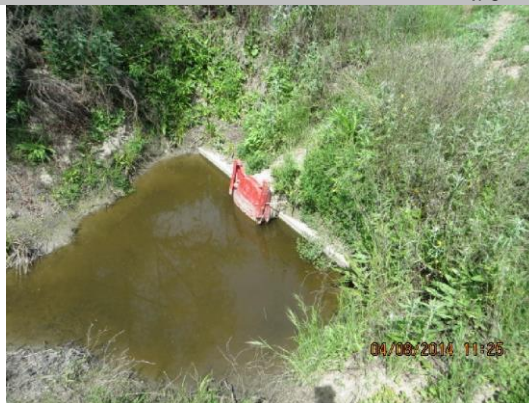
Photo 2 of 3 : UCIP\_SP\_2018\_39140\_60732.jpg

FS\_ID:39140  
DS\_ID:19608  
EP\_NO: N/A  
Repair Type: Non-Urgent  
Crossing Status: Found  
UCIP Comments: Dense vegetation and fence limits the inspector's visibility to identify signs of pipe failure (leaks) along the landward side. Recommend obtaining access to landward toe and removing vegetation along pipe alignment to conduct proper inspection of structure and appurtenances.  
FIELD\_STRUCT\_DESC: 24-inch corrugated metal gravity drainage pipe through the levee, 11.9 feet below the crown. Flap gate on the waterside (WS) end. Brass cap No. 90 bench mark (BM) on the headwall on the landside (LS). [Additional Reference(s): DWR Levee Log, 2002. USACE San Joaquin O&M Manual 601.1, 1967, (HLM 4.27)].  
FS Date: 4/8/2014

Pipe, flapgate, and headwall visible at WS toe.

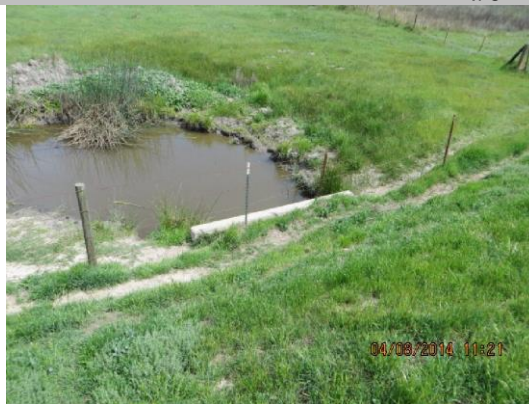
Photo 3 of 3 : UCIP\_SP\_2018\_39140\_60734.jpg

Concrete headwall at LS toe.

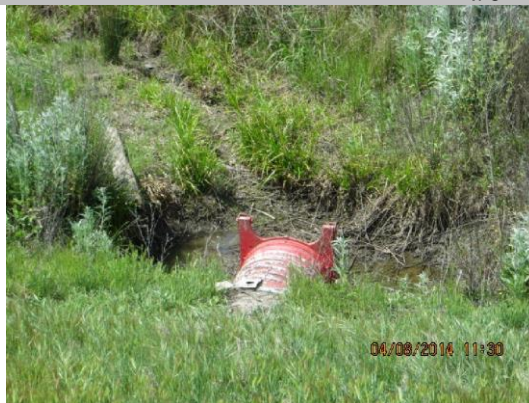
Photo 1 of 3 : UCIP\_SP\_2018\_39141\_60737.jpg

FS\_ID:39141  
DS\_ID:19609  
EP\_NO: N/A  
Repair Type: Non-Urgent  
Crossing Status: Found  
UCIP Comments: Dense vegetation limits the inspector's visibility to identify signs of pipe failure (leaks) along the waterward side. Recommend removing vegetation along pipe alignment to conduct proper inspection of structure and appurtenances.  
FIELD\_STRUCT\_DESC: 24-inch corrugated metal gravity drainage pipe through the levee, 10 feet below the crown. Flap gate on the waterside (WS) end. Brass cap No. 90 bench mark (BM) on the headwall on the landside (LS). [Additional Reference(s): DWR Levee Log, 2002. USACE San Joaquin O&M Manual 601.1, 1967, (HLM 4.72)].  
FS Date: 4/8/2014

Pipe, flapgate, and headwall on WS toe.

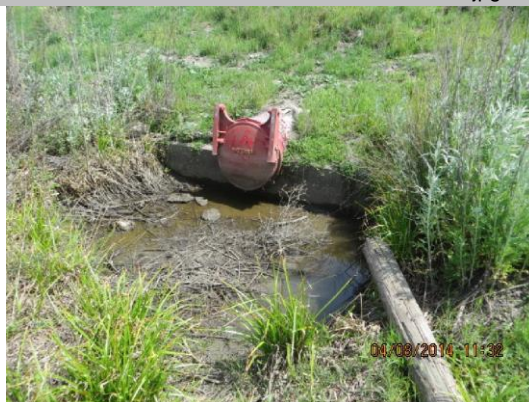
Photo 2 of 3 : UCIP\_SP\_2018\_39141\_60738.jpg

Pipe, flapgate, and headwall on WS toe.

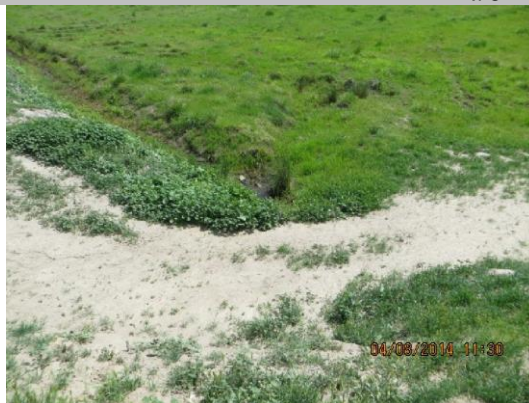
Photo 3 of 3 : UCIP\_SP\_2018\_39141\_60736.jpg

Comment Code						
Inspector Comment						
FS_ID:39141 DS_ID:19609 EP_NO: N/A Repair Type: Non-Urgent Crossing Status: Found UCIP Comments: Dense vegetation limits the inspector's visibility to identify signs of pipe failure (leaks) along the waterward side. Recommend removing vegetation along pipe alignment to conduct proper inspection of structure and appurtenances. FIELD_STRUCT_DESC: 24-inch corrugated metal gravity drainage pipe through the levee, 10 feet below the crown. Flap gate on the waterside (WS) end. Brass cap No. 90 bench mark (BM) on the headwall on the landside (LS). [Additional Reference(s): DWR Levee Log, 2002. USACE San Joaquin O&M Manual 601.1, 1967, (HLM 4.72)]. FS Date: 4/8/2014

Pipe and concrete headwall on LS toe.

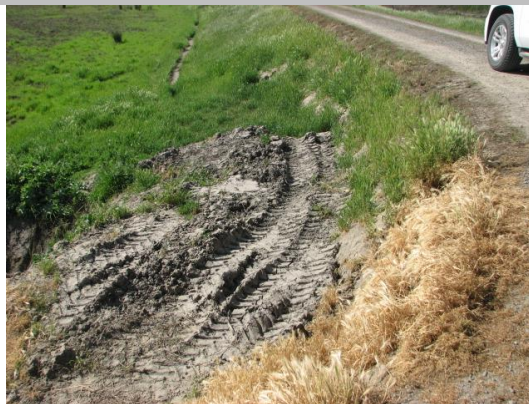
Photo 1 of 3 : SP\_2018\_NA0010\_118\_9\_20180420\_00271.jpg

LM Start	4.69	Rating **	A/W	Issue No.	9
LM End	4.69	Issue Type +	Ma	Location *	LS
Category	Earthen Levee			GPS Latitude/Longitude	
				Start	End
Item	Erosion / Bank Caving			37.302398 °	37.302398 °
				-120.920920 °	-120.920920 °
DWR ID	DWR_NA0010_01_s_2013_9				
Comment Code					
Inspector Comment					
Levee landside toe damaged by livestock.

Looking south at fill poorly placed on landward slope and toe. (Spring 2018)

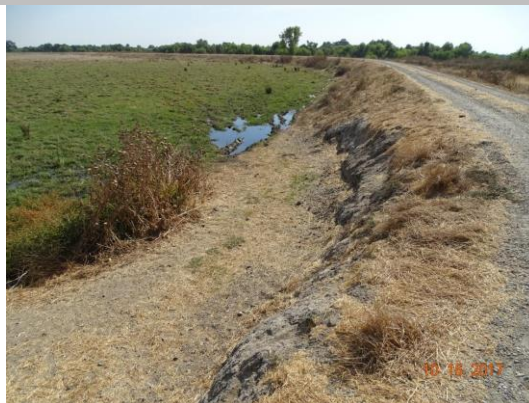
Photo 2 of 3 : SP\_2018\_NA0010\_118\_9\_20180307\_00006.jpg

LM Start	4.69	Rating **	A/W	Issue No.	9 (cont)	
LM End	4.69	Issue Type +	Ma	Location *	LS	
Category	Earthen Levee			GPS Latitude/Longitude		
				Start		End
Item	Erosion / Bank Caving			37.302398 °	37.302398 °	
				-120.920920 °	-120.920920 °	
DWR ID	DWR_NA0010_01_s_2013_9					
Comment Code						
Inspector Comment						
Levee landside toe damaged by livestock.

Looking south at landside.

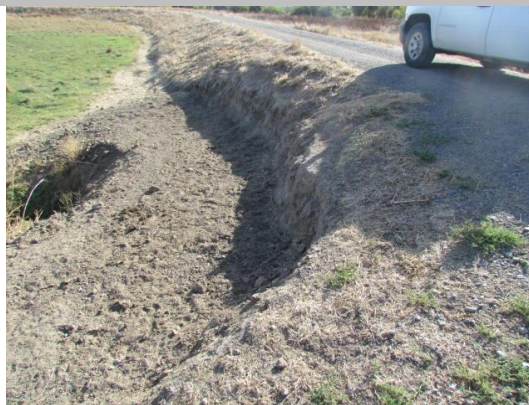
Photo 3 of 3 : SP\_2018\_NA0010\_118\_9\_20180307\_00007.jpg

Looking at landward slope damaged by livestock.

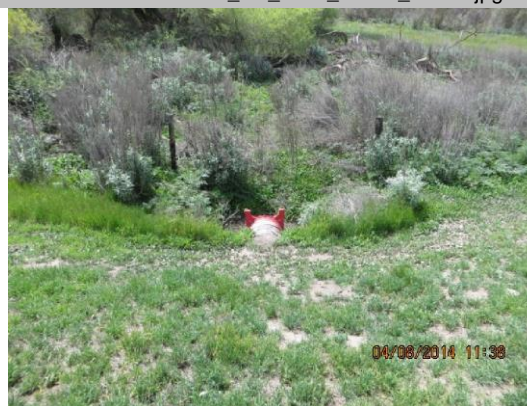
Photo 1 of 2 : UCIP\_SP\_2018\_39143\_60740.jpg

LM Start	5.02	Rating **	M	Issue No.	1208	
LM End	5.02	Issue Type +	Ma	Location *		
Category	Supplemental			GPS Latitude/Longitude		
				Start		End
Item	DWR UCIP LMA Responsibility			37.298917 °		37.298917 °
				-120.917262 °		-120.917262 °
DWR ID						
Comment Code						
Inspector Comment						
FS_ID:39143 DS_ID:19610 EP_NO: N/A Repair Type: Non-Urgent Crossing Status: Found UCIP Comments: Non-functional -- sediment buildup against flapgate and inlet buried at landward side. FIELD_STRUCT_DESC: 24-inch corrugated metal gravity drainage pipe through the levee, 8 feet below the crown. Flap gate on the waterside (WS) end. Brass cap No. 90 bench mark (BM) on the headwall on the landside (LS). [Additional Reference(s): DWR Levee Log, 2002. USACE San Joaquin O&M Manual 601.1, 1967, (HLM 5.05)]. FS Date: 4/8/2014

Flapgate and headwall visible at WS toe.

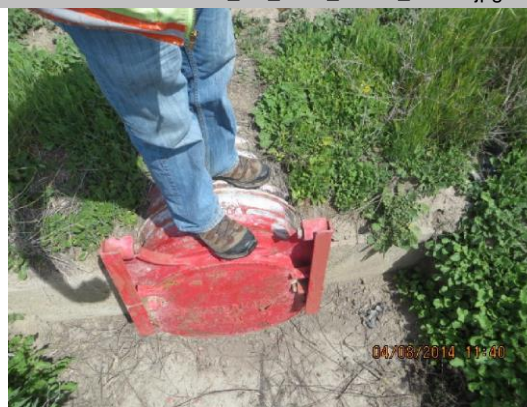
Photo 2 of 2 : UCIP\_SP\_2018\_39143\_60739.jpg

Flapgate and headwall visible at WS toe.
