**Flood Control Project Maintenance  
Levee Inspections**  
**LMA District Cover Sheet**  
**Spring 2018 Levee Inspection Results**

**Lower San Joaquin Levee District**

**Spring 2018 Levee Inspection Results**

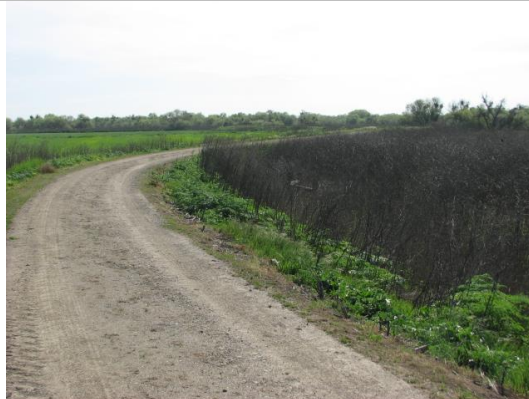
Photo 1 of 1 : SP\_2018\_NA0010\_118\_107\_20180420\_00272.jpg

LM Start	5.74	Rating **	U	Issue No.	107
LM End	6.20	Issue Type +	Ma	Location *	WS
Category	Earthen Levee			GPS Latitude/Longitude	
				Start	End
Item	Vegetation			37.304179 °	37.304911 °
				-120.906860 °	-120.899002 °
DWR ID	DWR_NA0010_01_f_2017_107				
Comment Code					
V2 : Remove the wild growth other than native grasses from the levee slopes.					
Inspector Comment

Looking south at dense veg on waterward slope. (Spring 2018)

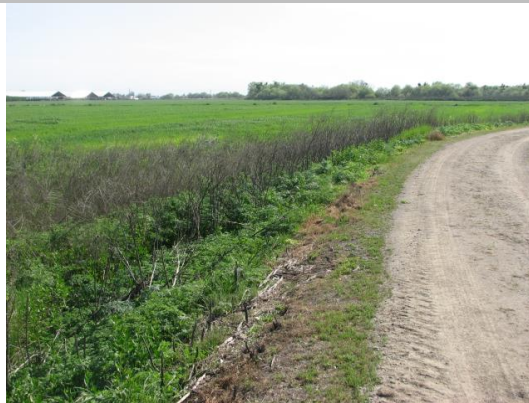
Photo 1 of 1 : SP\_2018\_NA0010\_118\_106\_20180420\_00273.jpg

LM Start	5.74	Rating **	U	Issue No.	106
LM End	6.20	Issue Type +	Ma	Location *	LS
Category	Earthen Levee			GPS Latitude/Longitude	
				Start	End
Item	Vegetation			37.304180 °	37.304911 °
				-120.906860 °	-120.899001 °
DWR ID	DWR_NA0010_01_f_2017_106				
Comment Code					
V2 : Remove the wild growth other than native grasses from the levee slopes.					
Inspector Comment

Looking south at dense veg on landward slope. (Spring 2018)

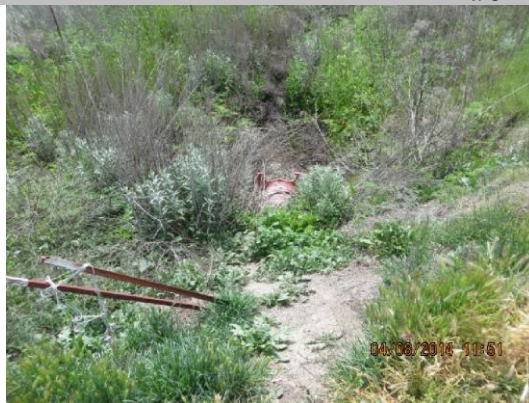
Photo 1 of 2 : UCIP\_SP\_2018\_39151\_60742.jpg

FS\_ID:39151  
DS\_ID:19611  
EP\_NO: N/A  
Repair Type: Non-Urgent  
Crossing Status: Found  
UCIP Comments: Dense vegetation limits the inspector's visibility to identify signs of pipe failure (leaks) along waterward and landward slopes. Recommend removing vegetation along pipe alignment to conduct proper inspection of structure and appurtenances. Landward side filled in with soil. Need to contact owner. If crossing is no longer used need to coordinate with CVFPB for proper abandonment.  
FIELD\_STRUCT\_DESC: 24-inch corrugated metal gravity drainage pipe through the levee, 8.6 feet below the crown. Flap gate on the waterside (WS) end. Brass cap No. 90 bench mark (BM) on the headwall on the landside (LS). [Additional Reference(s): DWR Levee Log, 2002. USACE San Joaquin O&M Manual 601.1, 1967, (HLM 5.95)].  
FS Date: 4/8/2014

Pipe, concrete headwall, and flapgate visible on WS toe.

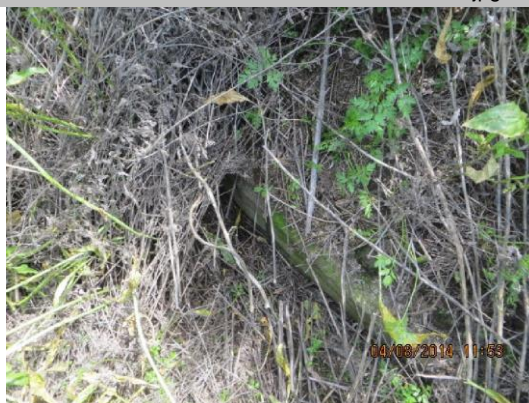
Photo 2 of 2 : UCIP\_SP\_2018\_39151\_60741.jpg

Top of concrete headwall just visible on LS toe.

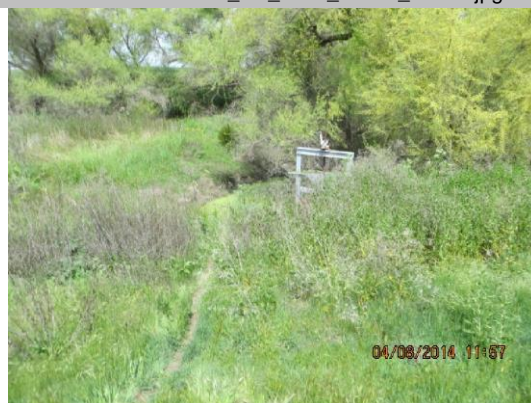
Photo 1 of 3 : UCIP\_SP\_2018\_39152\_60745.jpg

Comment Code						
Inspector Comment						
FS_ID:39152 DS_ID:19612 EP_NO: N/A Repair Type: Non-Urgent Crossing Status: Found UCIP Comments: Dense vegetation limits the inspector's visibility to identifying signs of pipe failure (leaks) along waterward and landward slopes. Recommend removing vegetation along pipe alignment to conduct proper inspection of structure and appurtenances. Pipe completely blocked by soil on LS toe due to animal activity. Slide gate blocked open. FIELD_STRUCT_DESC: 48-inch corrugated metal gravity drainage pipe through the levee, 13.1 feet below the crown. Walkway to slide gate at the concrete headwall on the landside (LS) toe. Flap gate at the concrete headwall on the waterside (WS) toe. Brass cap No. 90 bench mark (BM) on the headwall on the LS. Pipe crosses the levee at an angle. [Additional Reference(s): DWR Levee Log, 2002. USACE San Joaquin O&M Manual 601.1, 1967, (HLM 6.13)]. FS Date: 4/8/2014

Slidegate at LS toe.

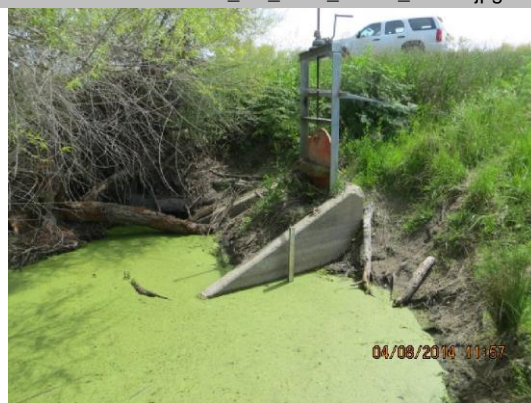
Photo 2 of 3 : UCIP\_SP\_2018\_39152\_60744.jpg

Pipe, concrete headwall, slidegate, and metal walkway on LS toe.

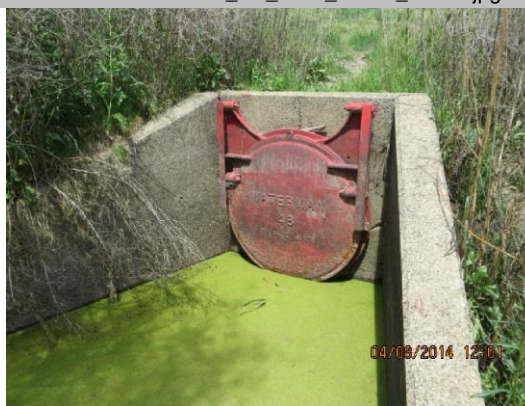
Photo 3 of 3 : UCIP\_SP\_2018\_39152\_60743.jpg

Comment Code						
Inspector Comment						
FS_ID:39152 DS_ID:19612 EP_NO: N/A Repair Type: Non-Urgent Crossing Status: Found UCIP Comments: Dense vegetation limits the inspector's visibility to identifying signs of pipe failure (leaks) along waterward and landward slopes. Recommend removing vegetation along pipe alignment to conduct proper inspection of structure and appurtenances. Pipe completely blocked by soil on LS toe due to animal activity. Slide gate blocked open. FIELD_STRUCT_DESC: 48-inch corrugated metal gravity drainage pipe through the levee, 13.1 feet below the crown. Walkway to slide gate at the concrete headwall on the landside (LS) toe. Flap gate at the concrete headwall on the waterside (WS) toe. Brass cap No. 90 bench mark (BM) on the headwall on the LS. Pipe crosses the levee at an angle. [Additional Reference(s): DWR Levee Log, 2002. USACE San Joaquin O&M Manual 601.1, 1967, (HLM 6.13)]. FS Date: 4/8/2014

Flapgate on concrete headwall at WS toe.

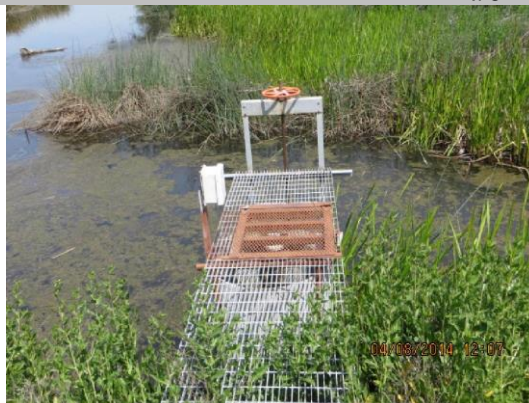
Photo 3 of 3 : UCIP\_SP\_2018\_39154\_60761.jpg

Comment Code						
Inspector Comment						
FS_ID:39154 DS_ID:19613 EP_NO: N/A Repair Type: Non-Urgent Crossing Status: Found UCIP Comments: Dense vegetation limits the inspector's visibility to identify signs of pipe failure (leaks) along the slope. Recommend removing vegetation along pipe alignment to conduct proper inspection of structure and appurtenances. FIELD_STRUCT_DESC: 24-inch corrugated metal gravity drainage pipe through the levee, 9.5 feet below the crown. Flap gate on the waterside (WS) end. Slide gate on the landside (LS) end next to a 48-inch concrete riser with walkway over the top. Brass cap No. 90 bench mark (BM) on the headwall on the LS. [Additional Reference(s): DWR Levee Log, 2002. USACE San Joaquin O&M Manual 601.1, 1967, (HLM 6.40)]. FS Date: 4/8/2014

Metal walkway over concrete standpipe next to slide gate on LS toe.

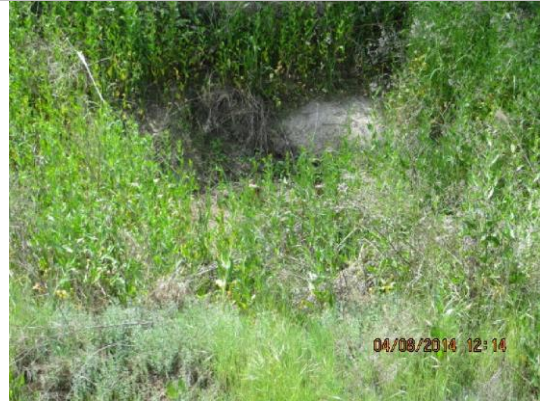
Photo 1 of 3 : UCIP\_SP\_2018\_49962\_60764.jpg

Comment Code						
Inspector Comment						
FS_ID:49962 DS_ID:19614 EP_NO: N/A Repair Type: Non-Urgent Crossing Status: Found UCIP Comments: 7/19/2016 Same as previous inspection. Outlet and inlet are under water. (DWR UCIP - omagana)4/08/2014 Flapgate blocked by sedimentation at WS toe. Dense vegetation limits the inspector's visibility to identify signs of pipe failure (leaks) along the slope. Recommend removing vegetation along pipe alignment to conduct proper inspection of structure and appurtenances. Also recommend clearing vegetation from both waterward and landward toe. (DWR UCIP - omagana) FIELD_STRUCT_DESC: 24-inch corrugated metal gravity drainage pipe through the levee, 9.8 feet below the crown. Wooden fence around a 4-foot by 4-foot drop inlet on the landside (LS) toe. Flap gate on the waterside (WS) end. Brass cap No. 90 bench mark (BM) on the headwall on the LS. [Additional Reference(s): DWR Levee Log, 2002. USACE San Joaquin O&M Manual 601.1, 1967, (HLM 6.64)]. FS Date: 7/19/2016

Pipe and flapgate visible on WS toe.

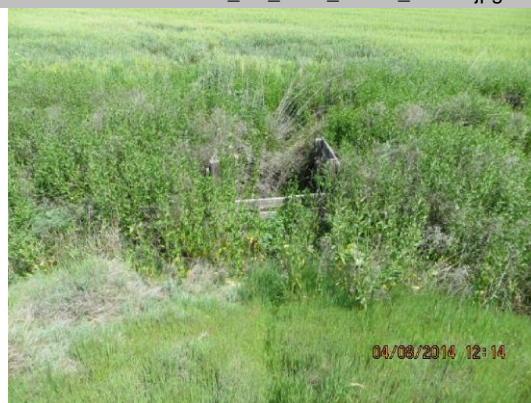
Photo 3 of 3 : UCIP\_SP\_2018\_49962\_60765.jpg

Comment Code						
Inspector Comment						
FS_ID:49962 DS_ID:19614 EP_NO: N/A Repair Type: Non-Urgent Crossing Status: Found UCIP Comments: 7/19/2016 Same as previous inspection. Outlet and inlet are under water. (DWR UCIP - omagana)4/08/2014 Flapgate blocked by sedimentation at WS toe. Dense vegetation limits the inspector's visibility to identify signs of pipe failure (leaks) along the slope. Recommend removing vegetation along pipe alignment to conduct proper inspection of structure and appurtenances. Also recommend clearing vegetation from both waterward and landward toe. (DWR UCIP - omagana) FIELD_STRUCT_DESC: 24-inch corrugated metal gravity drainage pipe through the levee, 9.8 feet below the crown. Wooden fence around a 4-foot by 4-foot drop inlet on the landside (LS) toe. Flap gate on the waterside (WS) end. Brass cap No. 90 bench mark (BM) on the headwall on the LS. [Additional Reference(s): DWR Levee Log, 2002. USACE San Joaquin O&M Manual 601.1, 1967, (HLM 6.64)]. FS Date: 7/19/2016

Wooden barrier around drop inlet on LS toe. Excess vegetation.

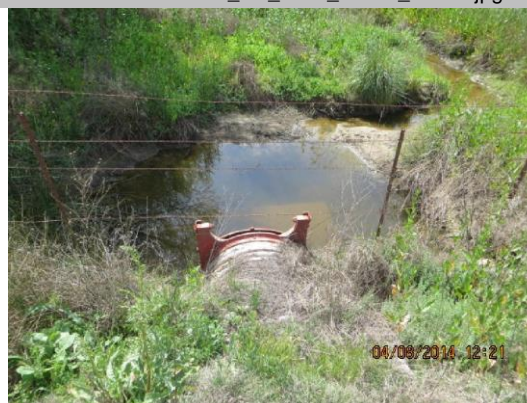
Photo 1 of 3 : UCIP\_SP\_2018\_50077\_60768.jpg

Comment Code						
Inspector Comment						
FS_ID:50077 DS_ID:19615 EP_NO: N/A Repair Type: Non-Urgent Crossing Status: Found UCIP Comments: 7/19/2016 Potential LS slope damage--difficult to determine due to dense vegetation. Limited access on WS toe due to wire fence. (DWR UCIP - omagana)4/08/2014 Slide gate blocked by debris at LS toe. Flapgate won't close because of debris. Dense vegetation limits the inspector's visibility to identify signs of pipe failure (leaks) along the slope. Recommend removing vegetation along pipe alignment to conduct proper inspection of structure and appurtenances. (DWR UCIP - omagana) FIELD_STRUCT_DESC: 36-inch corrugated metal gravity drainage pipe through the levee, 10.3 feet below the crown. Slide gate on the landside (LS) toe. Flap gate on the waterside (WS) end. Brass cap No. 90 bench mark (BM) on the headwall on the LS. [Additional Reference(s): DWR Levee Log, 2002. USACE San Joaquin O&M Manual 601.1, 1967, (HLM 6.90)]. FS Date: 7/19/2016

Pipe, headwall, and flapgate on WS toe.

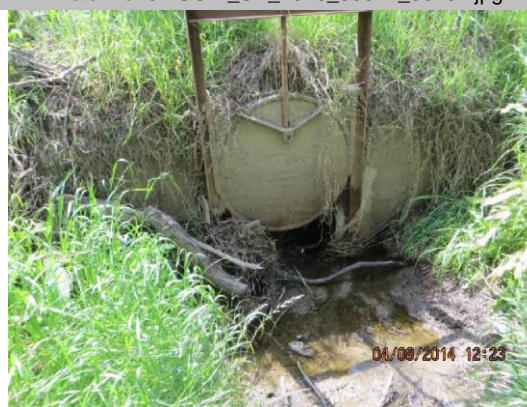
Photo 2 of 3 : UCIP\_SP\_2018\_50077\_60767.jpg

Pipe, concrete headwall, and slidegate on LS toe. Debris blocking closure of slidegate.

Comment Code						
Inspector Comment						
FS_ID:50077 DS_ID:19615 EP_NO: N/A Repair Type: Non-Urgent Crossing Status: Found UCIP Comments: 7/19/2016 Potential LS slope damage--difficult to determine due to dense vegetation. Limited access on WS toe due to wire fence. (DWR UCIP - omagana)4/08/2014 Slide gate blocked by debris at LS toe. Flapgate won't close because of debris. Dense vegetation limits the inspector's visibility to identify signs of pipe failure (leaks) along the slope. Recommend removing vegetation along pipe alignment to conduct proper inspection of structure and appurtenances. (DWR UCIP - omagana) FIELD_STRUCT_DESC: 36-inch corrugated metal gravity drainage pipe through the levee, 10.3 feet below the crown. Slide gate on the landside (LS) toe. Flap gate on the waterside (WS) end. Brass cap No. 90 bench mark (BM) on the headwall on the LS. [Additional Reference(s): DWR Levee Log, 2002. USACE San Joaquin O&M Manual 601.1, 1967, (HLM 6.90)]. FS Date: 7/19/2016

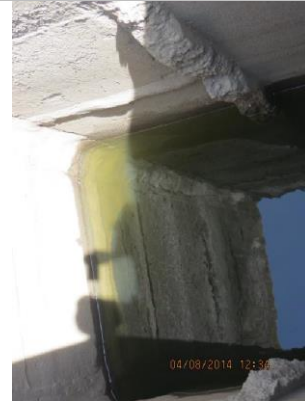
Photo 1 of 3 : UCIP\_SP\_2018\_39160\_60776.jpg

Comment Code						
Inspector Comment						
FS_ID:39160 DS_ID:19617 EP_NO: 4425 Repair Type: Non-Urgent Crossing Status: Found UCIP Comments: Recommend contacting owner to determine status of crossing. No pump was found on waterward side (riverbank). If crossing is no longer used need to coordinate with CVFPB for proper abandonment. FIELD_STRUCT_DESC: 24-inch concrete encased steel irrigation discharge pipe through the levee, 13.6 feet below the crown. Pipe encased in 6-inches of concrete through the levee. 5-foot by 7-foot concrete distribution box on the waterside (WS). 20-inch concrete standpipe at the landside (LS) toe. Pump on the riverbank, accessible by walkway platform, pump not found. Concrete cutoff walls around pipe in line with the levee shoulders. Pipe extends to 36-inch concrete pipes on both sides of the levee. (Plans to install an irrigation pipeline through the levee authorized under Permit No. 4425, 1964 - James J. Stevinson, a Corporation). [Additional Reference(s): DWR Levee Log, 2002]. FS Date: 4/8/2014

Pipe visible under water in concrete box riser on WS toe.

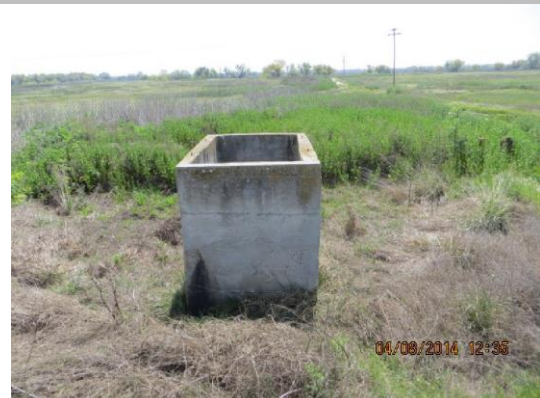
Photo 2 of 3 : UCIP\_SP\_2018\_39160\_60775.jpg

5'X7' concrete box riser on WS toe.

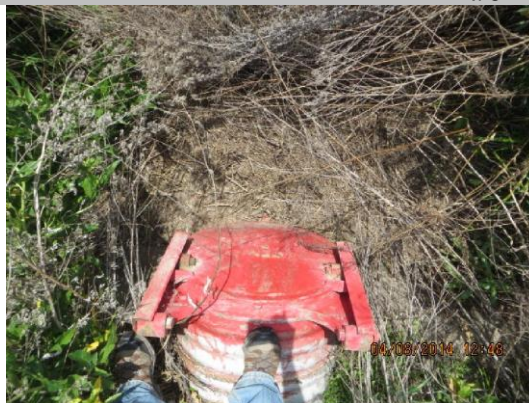
Photo 2 of 3 : UCIP\_SP\_2018\_39243\_60840.jpg

Comment Code						
Inspector Comment						
FS_ID:39243 DS_ID:19619 EP_NO: N/A Repair Type: Non-Urgent Crossing Status: Found UCIP Comments: Dense vegetation limits the inspector's visibility to identify signs of pipe failure (leaks) along the slope. Recommend removing vegetation along pipe alignment to conduct proper inspection of structure. FIELD_STRUCT_DESC: 24-inch corrugated metal gravity drainage pipe through the levee, 10 feet below the crown. Flap gate on the waterside (WS) end. Brass cap No. 80 bench mark (BM) on the headwall on the landside (LS). [Additional Reference(s): DWR Levee Log, 2002. USACE San Joaquin O&M Manual 601.1, 1967, (HLM 7.69)]. FS Date: 4/8/2014

Flapgate and headwall at WS toe.

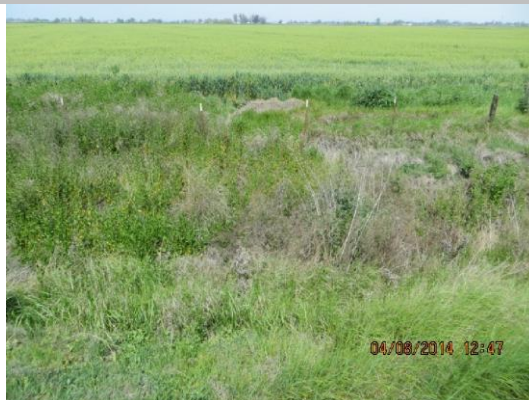
Photo 3 of 3 : UCIP\_SP\_2018\_39243\_60841.jpg

Concrete headwall at LS toe. Heavy vegetation on both slopes.

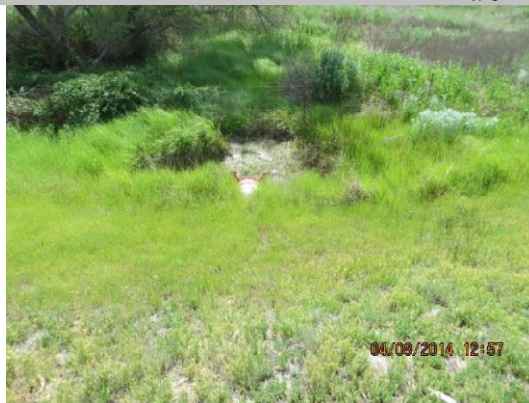
Photo 1 of 3 : UCIP\_SP\_2018\_39244\_60844.jpg

Comment Code						
Inspector Comment						
FS_ID:39244 DS_ID:19620 EP_NO: N/A Repair Type: Non-Urgent Crossing Status: Found UCIP Comments: Dense vegetation limits the inspector's visibility to identify signs of pipe failure (leaks) along the slope. Recommend removing vegetation along pipe alignment to conduct proper inspection of structure. FIELD_STRUCT_DESC: 24-inch corrugated metal gravity drainage pipe through the levee, 8 feet below the crown. Flap gate on the waterside (WS) end. Brass cap No. 80 bench mark (BM) on the headwall on the landside (LS). [Additional Reference(s): DWR Levee Log, 2002. USACE San Joaquin O&M Manual 601.1, 1967, (HLM 8.07)]. FS Date: 4/9/2014

Pipe, Headwall, and flapgate at WS toe.

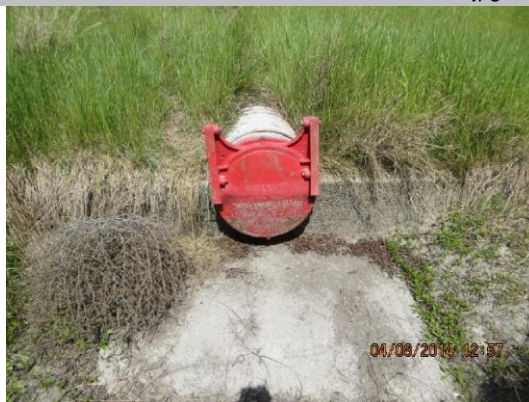
Photo 2 of 3 : UCIP\_SP\_2018\_39244\_60847.jpg

Pipe, Headwall, and flapgate at WS toe.

Comment Code						
Inspector Comment						
FS_ID:39244 DS_ID:19620 EP_NO: N/A Repair Type: Non-Urgent Crossing Status: Found UCIP Comments: Dense vegetation limits the inspector's visibility to identify signs of pipe failure (leaks) along the slope. Recommend removing vegetation along pipe alignment to conduct proper inspection of structure. FIELD_STRUCT_DESC: 24-inch corrugated metal gravity drainage pipe through the levee, 8 feet below the crown. Flap gate on the waterside (WS) end. Brass cap No. 80 bench mark (BM) on the headwall on the landside (LS). [Additional Reference(s): DWR Levee Log, 2002. USACE San Joaquin O&M Manual 601.1, 1967, (HLM 8.07)]. FS Date: 4/9/2014

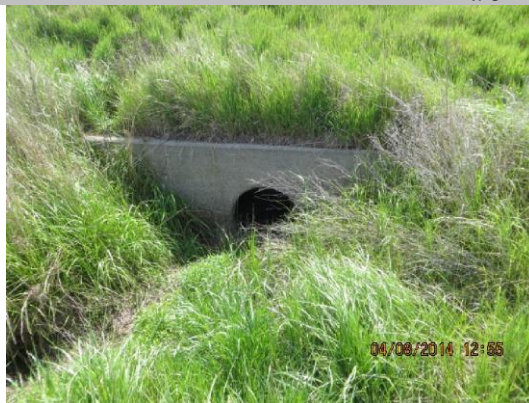
Photo 3 of 3 : UCIP\_SP\_2018\_39244\_60846.jpg

Pipe and concrete headwall on LS toe.

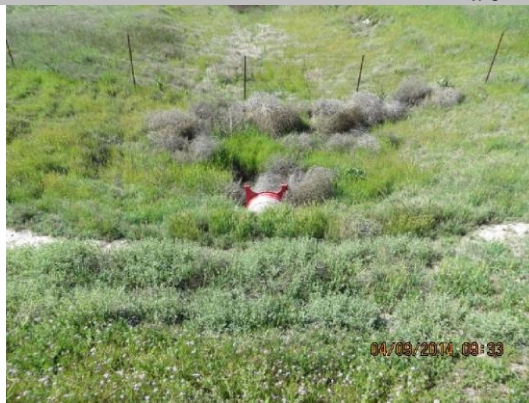
Photo 1 of 3 : UCIP\_SP\_2018\_39245\_60850.jpg

Comment Code					
Inspector Comment					
FS_ID:39245 DS_ID:19621 EP_NO: N/A Repair Type: Non-Urgent Crossing Status: Found UCIP Comments: Dense vegetation limits the inspector's visibility to identify signs of pipe failure (leaks) along the slope. Recommend removing vegetation along pipe alignment to conduct proper inspection of structure. Sediment buildup at landward toe. FIELD_STRUCT_DESC: 24-inch corrugated metal gravity drainage pipe through the levee, 9.5 feet below the crown. Flap gate on the waterside (WS) end. Brass cap No. 80 bench mark (BM) on the headwall on the landside (LS). [Additional Reference(s): DWR Levee Log, 2002. USACE San Joaquin O&M Manual 601.1, 1967, (HLM 8.41)]. FS Date: 4/9/2014

Concrete headwall, pipe, and flapgate at WS toe.

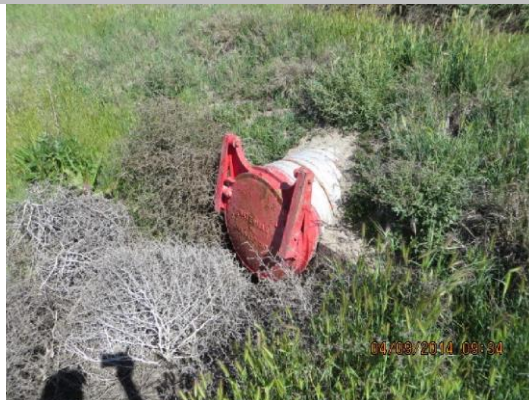
Photo 2 of 3 : UCIP\_SP\_2018\_39245\_60848.jpg

Concrete headwall, pipe, and flapgate at WS toe.

Comment Code						
Inspector Comment						
FS_ID:39245						
DS_ID:19621						
EP_NO: N/A						
Repair Type: Non-Urgent						
Crossing Status: Found						
UCIP Comments: Dense vegetation limits the inspector's visibility to						
identify signs of pipe failure (leaks) along the slope. Recommend						
removing vegetation along pipe alignment to conduct proper inspection						
of structure. Sediment buildup at landward toe.						
FIELD_STRUCT_DESC: 24-inch corrugated metal gravity drainage pipe						
through the levee, 9.5 feet below the crown. Flap gate on the waterside						
(WS) end. Brass cap No. 80 bench mark (BM) on the headwall on the						
landside (LS). [Additional Reference(s): DWR Levee Log, 2002. USACE						
San Joaquin O&M Manual 601.1, 1967, (HLM 8.41)].						
FS Date: 4/9/2014

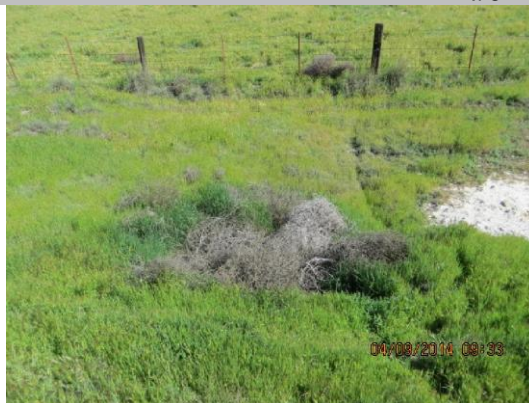
Photo 3 of 3 : UCIP\_SP\_2018\_39245\_60849.jpg

Pipe and concrete headwall at LS toe. Note heavy vegetation.

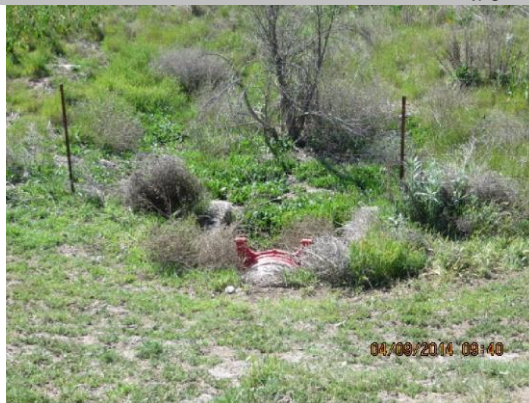
Photo 1 of 3 : UCIP\_SP\_2018\_39246\_60854.jpg

LM Start	8.57	Rating **	A/W	Issue No.	1220
LM End	8.57	Issue Type +	Ma	Location *	
Category	Supplemental			GPS Latitude/Longitude	
				Start	End
Item	DWR UCIP LMA Responsibility			37.296552 °	37.296552 °
				-120.858596 °	-120.858596 °
DWR ID					
Comment Code					
Inspector Comment					
FS_ID:39246					
DS_ID:19622					
EP_NO: N/A					
Repair Type: No Action Needed					
Crossing Status: Found					
UCIP Comments:					
FIELD_STRUCT_DESC: 24-inch corrugated metal gravity drainage pipe					
through the levee, 9 feet below the crown. Flap gate on the waterside					
(WS) end. Brass cap No. 80 bench mark (BM) on the headwall on the					
landside (LS). [Additional Reference(s): DWR Levee Log, 2002. USACE					
San Joaquin O&M Manual 601.1, 1967, (HLM 8.61)].					
FS Date: 4/9/2014

Pipe, Flapgate, and headwall on WS toe.

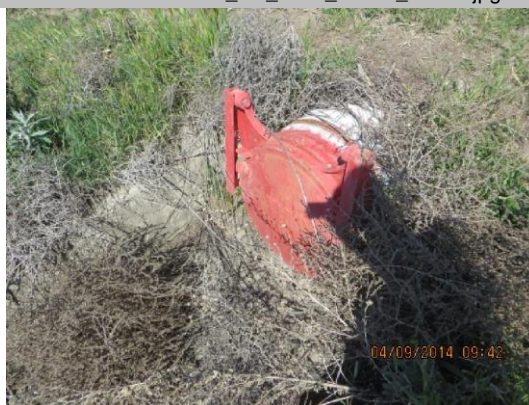
Photo 2 of 3 : UCIP\_SP\_2018\_39246\_60855.jpg

Pipe, Flapgate, and headwall on WS toe.

LM Start	8.57	Rating **	A/W	Issue No.	1220 (cont)	
LM End	8.57	Issue Type +	Ma	Location *		
Category	Supplemental			GPS Latitude/Longitude		
				Start	End	
Item	DWR UCIP LMA Responsibility			37.296552 °	37.296552 °	
				-120.858596 °	-120.858596 °	
DWR ID						
Comment Code						
Inspector Comment						
FS_ID:39246						
DS_ID:19622						
EP_NO: N/A						
Repair Type: No Action Needed						
Crossing Status: Found						
UCIP Comments:						
FIELD_STRUCT_DESC: 24-inch corrugated metal gravity drainage pipe						
through the levee, 9 feet below the crown. Flap gate on the waterside						
(WS) end. Brass cap No. 80 bench mark (BM) on the headwall on the						
landside (LS). [Additional Reference(s): DWR Levee Log, 2002. USACE						
San Joaquin O&M Manual 601.1, 1967, (HLM 8.61)].						
FS Date: 4/9/2014

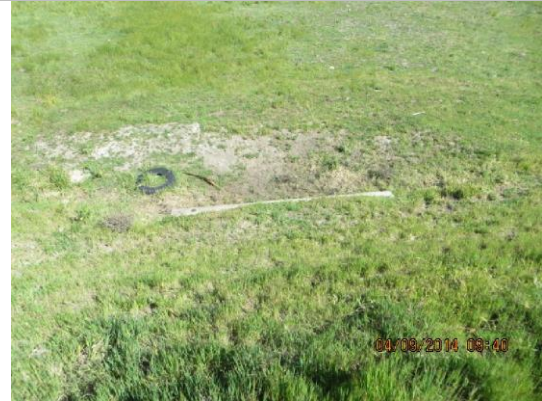
Photo 3 of 3 : UCIP\_SP\_2018\_39246\_60853.jpg

Pipe and headwall at LS toe.

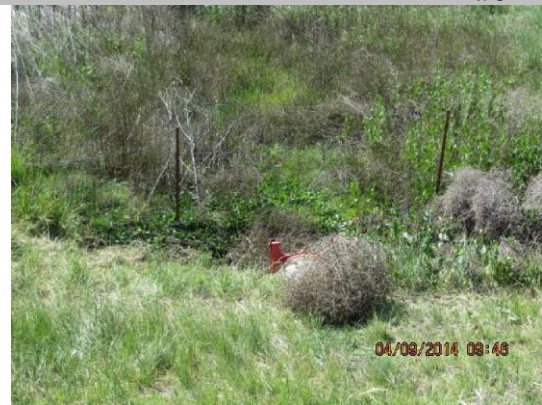
Photo 1 of 3 : UCIP\_SP\_2018\_39247\_60859.jpg

Comment Code						
Inspector Comment						
FS_ID:39247 DS_ID:19623 EP_NO: N/A Repair Type: Non-Urgent Crossing Status: Found UCIP Comments: Dense vegetation limits the inspector's visibility to identify signs of pipe failure (leaks) along the slope. Recommend removing vegetation along pipe alignment to conduct proper inspection of structure. FIELD_STRUCT_DESC: 24-inch corrugated metal gravity drainage pipe through the levee, 9.1 feet below the crown. Flap gate on the waterside (WS) end. Brass cap No. 80 bench mark (BM) on the headwall on the landside (LS). [Additional Reference(s): DWR Levee Log, 2002. USACE San Joaquin O&M Manual 601.1, 1967, (HLM 8.93)]. FS Date: 4/9/2014

Pipe, flapgate, and headwall on WS toe.

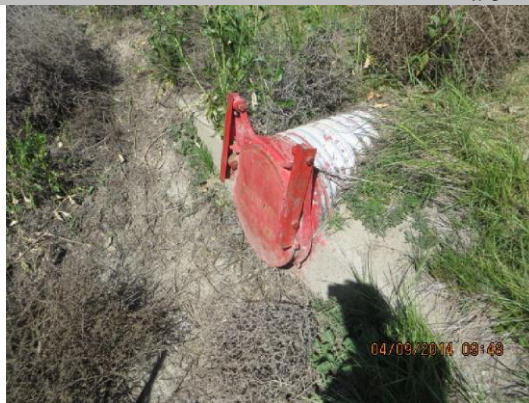
Photo 2 of 3 : UCIP\_SP\_2018\_39247\_60860.jpg

Comment Code						
Inspector Comment						
FS_ID:39247 DS_ID:19623 EP_NO: N/A Repair Type: Non-Urgent Crossing Status: Found UCIP Comments: Dense vegetation limits the inspector's visibility to identify signs of pipe failure (leaks) along the slope. Recommend removing vegetation along pipe alignment to conduct proper inspection of structure. FIELD_STRUCT_DESC: 24-inch corrugated metal gravity drainage pipe through the levee, 9.1 feet below the crown. Flap gate on the waterside (WS) end. Brass cap No. 80 bench mark (BM) on the headwall on the landside (LS). [Additional Reference(s): DWR Levee Log, 2002. USACE San Joaquin O&M Manual 601.1, 1967, (HLM 8.93)]. FS Date: 4/9/2014

Pipe, flapgate, and headwall on WS toe.

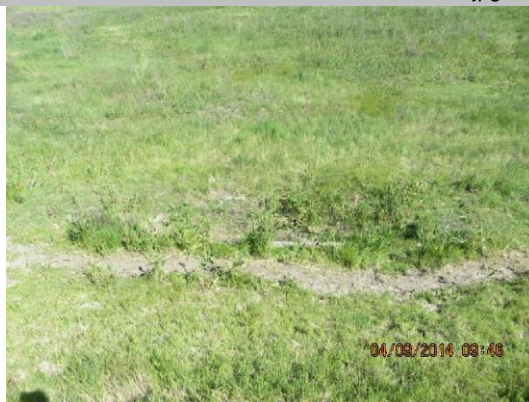
Photo 3 of 3 : UCIP\_SP\_2018\_39247\_60858.jpg

Pipe and headwall visible on LS toe.

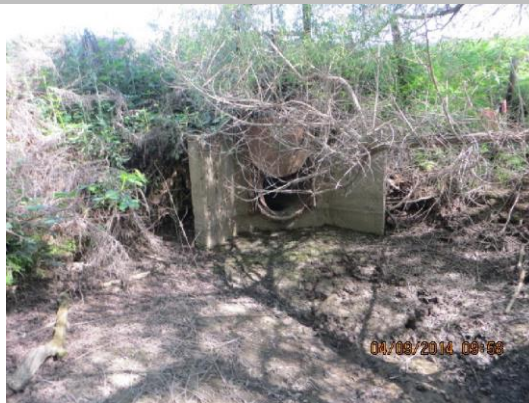
Photo 2 of 3 : UCIP\_SP\_2018\_49964\_60862.jpg

FS\_ID:49964  
DS\_ID:19624  
EP\_NO: 12156  
Repair Type: Urgent  
Crossing Status: Found  
UCIP Comments: 7/19/2016 same as previous inspection--pipe rusted through. Sediment visible inside LS pipe; walkway wood panels have dry rot and appears to be unsafe to use. (DWR UCIP - omagana)4/09/2014 Slide gate rusted through and open on WS toe. Inlet appears to be obscured or covered in soil at LS toe. Also dense vegetation on waterward and landward sides. Need to contact owner to contact CVFPB to address issue. (DWR UCIP - omagana)  
FIELD\_STRUCT\_DESC: 26-inch steel pipe sleeved through a 30-inch reinforced concrete gravity drainage pipe through the levee, 7.3 feet below the crown. Annular space grouted between the two pipes. Two concrete cutoff walls in the center of the levee. Slide gate with elevated walkway access on the waterside (WS) end. 6-inch thick concrete headwall on the WS end. Concrete wing walls on each end. (Plans to install a 30-inch storm drainage pipe with a valve through the levee authorized under Permit No. 12156, 1977 - Merquin County Water District). (Additional Related Permit(s): Permit No. 12156-A, 1978 - Merquin County Water District). [Additional Reference(s): DWR Levee Log, 2002].

Slidegate and headwall at WS toe.

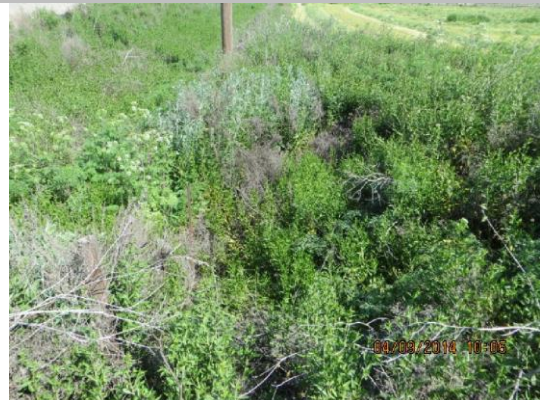
Photo 1 of 2 : UCIP\_SP\_2018\_39250\_60872.jpg

Comment Code						
Inspector Comment						
FS_ID:39250 DS_ID:19626 EP_NO: N/A Repair Type: Non-Urgent Crossing Status: Found UCIP Comments: Dense vegetation limits the inspector's visibility to identify signs of pipe failure (leaks) along the slope. Recommend removing vegetation along pipe alignment to conduct proper inspection of structure. FIELD_STRUCT_DESC: 24-inch corrugated metal gravity drainage pipe through the levee, 10 feet below the crown. Flap gate on the waterside (WS) end. Brass cap No. 80 bench mark (BM) on the headwall on the landside (LS). [Additional Reference(s): DWR Levee Log, 2002. USACE San Joaquin O&M Manual 601.1, 1967, (HLM 9.03)]. FS Date: 4/9/2014

Heavy vegetation on LS toe.

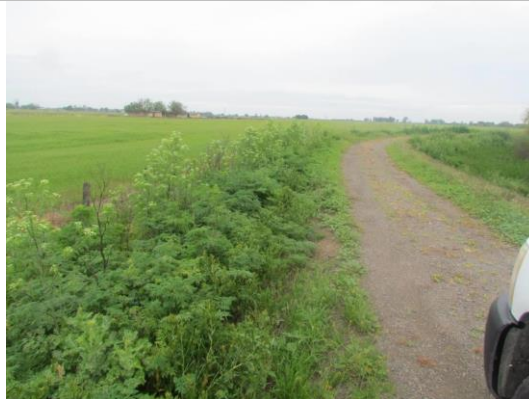
Photo 1 of 1 : SP\_2018\_NA0010\_118\_6\_20180307\_00004.jpg

LM Start	8.99	Rating **	U	Issue No.	6
LM End	9.61	Issue Type +	Ma	Location *	LS
Category	Earthen Levee			GPS Latitude/Longitude	
				Start	End
Item	Vegetation			37.297497 °	37.295138 °
				-120.851068 °	-120.840857 °
DWR ID	DWR_NA0010_01_s_2017_6				
Comment Code					
V2 : Remove the wild growth other than native grasses from the levee slopes.					
Inspector Comment

Looking south at dense veg on landward slope.

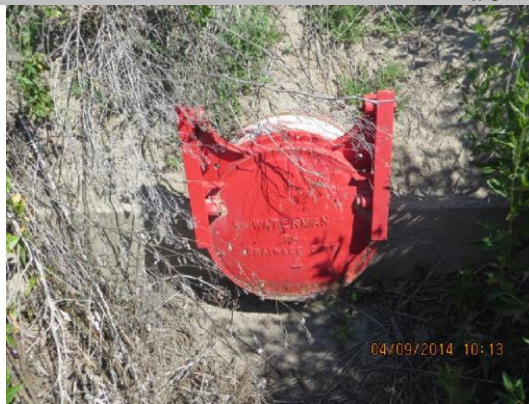
Photo 2 of 3 : UCIP\_SP\_2018\_39251\_60876.jpg

Headwall, Pipe, and flapgate on WS toe.

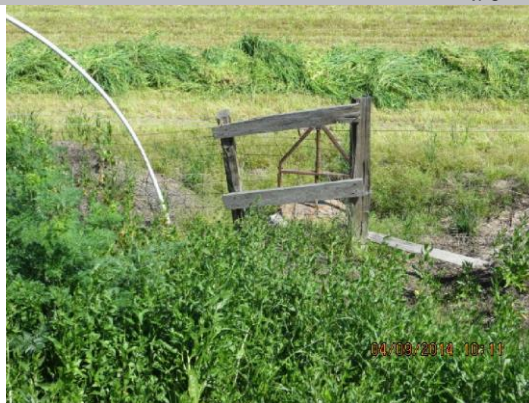
Photo 3 of 3 : UCIP\_SP\_2018\_39251\_60874.jpg

Comment Code						
Inspector Comment						
FS_ID:39251						
DS_ID:19627						
EP_NO: N/A						
Repair Type: Non-Urgent						
Crossing Status: Found						
UCIP Comments: Dense vegetation limits the inspector's visibility to identify signs of pipe failure (leaks) along the slope. Recommend removing vegetation along pipe alignment to conduct proper inspection of structure.						
FIELD_STRUCT_DESC: 24-inch corrugated metal gravity drainage pipe through the levee, 8.6 feet below the crown. Concrete drop inlet at the landside (LS) toe. Flap gate on the waterside (WS) end. Brass cap No. 80 bench mark (BM) on the headwall on the LS. [Additional Reference(s): DWR Levee Log, 2002. USACE San Joaquin O&M Manual 601.1, 1967, (HLM 9.37)].						
FS Date: 4/9/2014

Concrete drop-inlet installed on pipe at LS toe.

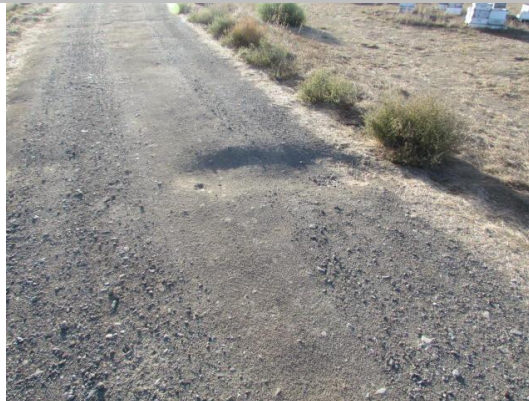
Photo 1 of 3 : SP\_2018\_NA0010\_118\_14\_20180307\_00010.jpg

LM Start	9.57	Rating **	A/W	Issue No.	14
LM End	9.57	Issue Type +	Ma	Location *	CR
Category	Earthen Levee			GPS Latitude/Longitude	
				Start	End
Item	Crown Surface / Depressions / Rutting			37.295517 °	37.295517 °
				-120.841452 °	-120.841452 °
DWR ID	DWR_NA0010_01_s_2015_14				
Comment Code					
C2 : Repair depressions or ruts in the crown or slope.					
Inspector Comment					
Depression greater than 3" deep by 18" wide by 18" long on levee crown

Looking at depression on levee crown. (Fall 2015)

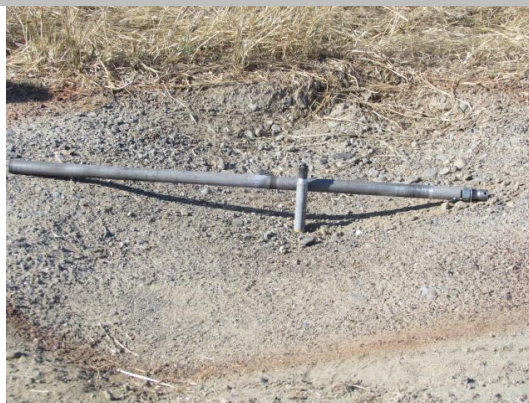
Photo 2 of 3 : SP\_2018\_NA0010\_118\_14\_20180307\_00011.jpg

Looking west at depression greater than three inches on levee crown.

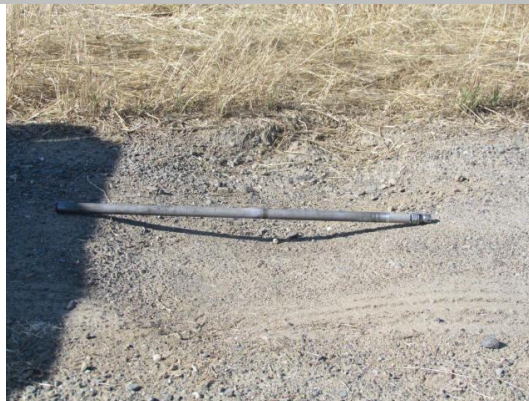
Photo 3 of 3 : SP\_2018\_NA0010\_118\_14\_20180307\_00012.jpg

Looking west at depression on levee crown.

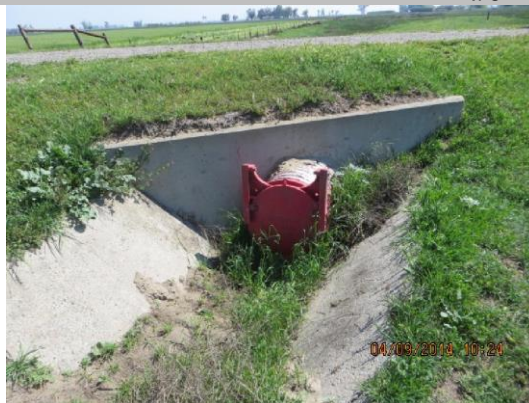
Photo 1 of 1 : UCIP\_SP\_2018\_33683\_60880.jpg

LM Start	9.64	Rating **	A/W	Issue No.	1226	
LM End	9.64	Issue Type +	Ma	Location *		
Category	Supplemental			GPS Latitude/Longitude		
				Start	End	
Item	DWR UCIP LMA Responsibility			37.294845 °	37.294845 °	
				-120.840580 °	-120.840580 °	
DWR ID						
Comment Code						
Inspector Comment						
FS_ID:33683						
DS_ID:19628						
EP_NO: N/A						
Repair Type: No Action Needed						
Crossing Status: Found						
UCIP Comments:						
FIELD_STRUCT_DESC: 24-inch corrugated metal gravity drainage pipe						
through the levee, 4.5 feet below the crown. Flap gate on the waterside						
(WS) end. Brass cap No. 80 bench mark (BM) on the headwall on the						
landside (LS). [Additional Reference(s): DWR Levee Log, 2002. USACE						
San Joaquin O&M Manual 601.1, 1967, (HLM 9.67)].						
FS Date: 4/9/2014

Pipe, flapgate, and headwall visible on WS toe.

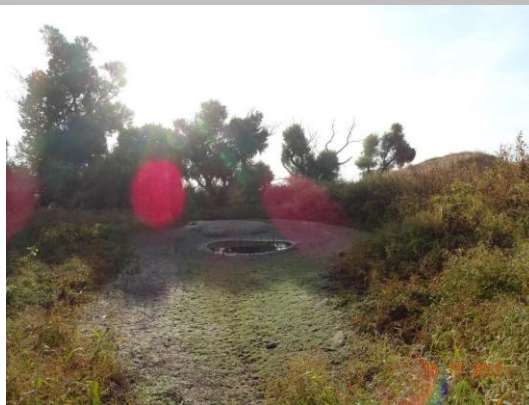
Photo 1 of 1 : SP\_2018\_NA0010\_118\_112\_20180307\_00025.jpg

LM Start	9.89	Rating **	A/W	Issue No.	112
LM End	9.90	Issue Type +	Ma	Location *	CR
Category	Earthen Levee			GPS Latitude/Longitude	
				Start	End
Item	Erosion / Bank Caving			37.291796 °	37.291581 °
				-120.839497 °	-120.839718 °
DWR ID	DWR_NA0010_01_f_2017_112				
Comment Code					
Inspector Comment					
Landowner degraded levee in the 1970's because Water on LS was flooding his property. Landowner has prevented efforts to restore levee. LMA has stated that no water from the waterside of the levee has ever backed up through the degraded levee and caused flooding.

Looking south at the levee bank caving.

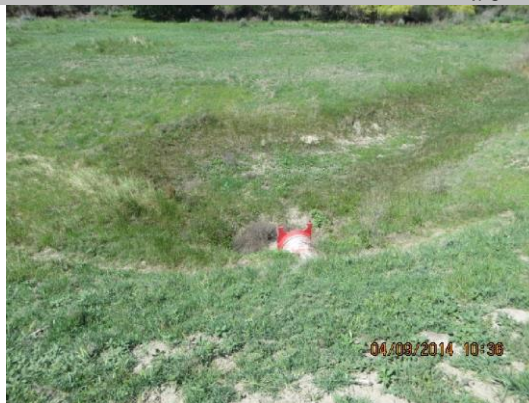
Photo 1 of 3 : UCIP\_SP\_2018\_39253\_60884.jpg

LM Start	10.20	Rating **	M	Issue No.	1227	
LM End	10.20	Issue Type +	Ma	Location *		
Category	Supplemental			GPS Latitude/Longitude		
				Start		End
Item	DWR UCIP LMA Responsibility			37.287511 °		37.287511 °
				-120.840251 °		-120.840251 °
DWR ID						
Comment Code						
Inspector Comment						
FS_ID:39253 DS_ID:19629 EP_NO: N/A Repair Type: Non-Urgent Crossing Status: Found UCIP Comments: Dense vegetation blocks waterward and landward toes Recommend removing vegetation from both toes. Also sediment buildup in pipe visible from landward side. FIELD_STRUCT_DESC: 24-inch corrugated metal gravity drainage pipe through the levee, 9 feet below the crown. Flap gate on the waterside (WS) end. Brass cap No. 69 bench mark (BM) on the headwall on the landside (LS). [Additional Reference(s): DWR Levee Log, 2002. USACE San Joaquin O&M Manual 601.1, 1967, (HLM 10.23)]. FS Date: 4/9/2014

Pipe, headwall, and flapgate on WS toe.

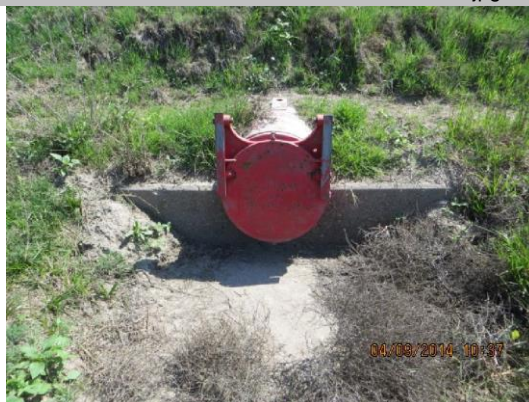
Photo 2 of 3 : UCIP\_SP\_2018\_39253\_60886.jpg

Pipe, headwall, and flapgate at WS toe.

Item	DWR UCIP LMA Responsibility			37.287511 °	37.287511 °	
				-120.840251 °	-120.840251 °	
DWR ID						
Comment Code						
Inspector Comment						
FS_ID:39253 DS_ID:19629 EP_NO: N/A Repair Type: Non-Urgent Crossing Status: Found UCIP Comments: Dense vegetation blocks waterward and landward toes Recommend removing vegetation from both toes. Also sediment buildup in pipe visible from landward side. FIELD_STRUCT_DESC: 24-inch corrugated metal gravity drainage pipe through the levee, 9 feet below the crown. Flap gate on the waterside (WS) end. Brass cap No. 69 bench mark (BM) on the headwall on the landside (LS). [Additional Reference(s): DWR Levee Log, 2002. USACE San Joaquin O&M Manual 601.1, 1967, (HLM 10.23)]. FS Date: 4/9/2014

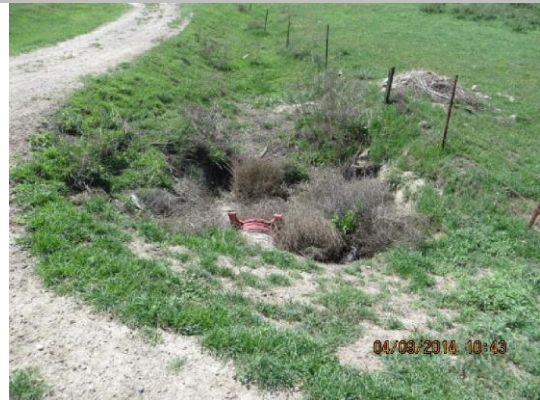
Photo 1 of 3 : UCIP\_SP\_2018\_33687\_60890.jpg

LM Start	10.68	Rating **	A/W	Issue No.	1228
LM End	10.68	Issue Type +	Ma	Location *	
Category	Supplemental			GPS Latitude/Longitude	
				Start	End
Item	DWR UCIP LMA Responsibility			37.283740 °	37.283740 °
				-120.833452 °	-120.833452 °
DWR ID					
Comment Code					
Inspector Comment					
FS_ID:33687					
DS_ID:19630					
EP_NO: N/A					
Repair Type: No Action Needed					
Crossing Status: Found					
UCIP Comments:					
FIELD_STRUCT_DESC: 24-inch corrugated metal gravity drainage pipe					
through the levee, 7 feet below the crown. Flap gate on the waterside					
(WS) end. Brass cap No. 68 bench mark (BM) on the headwall on the					
landside (LS). [Additional Reference(s): DWR Levee Log, 2002. USACE					
San Joaquin O&M Manual 601.1, 1967, (HLM 10.72)].					
FS Date: 4/9/2014

Pipe and flapgate on Ws toe.

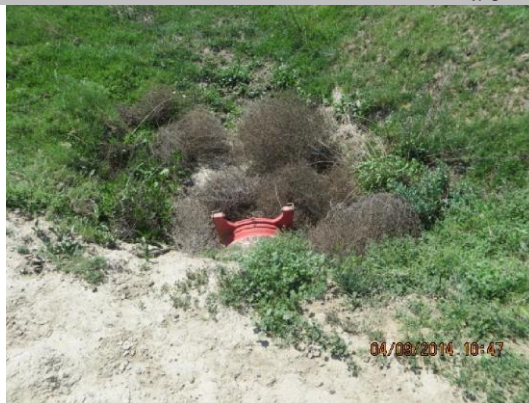
Photo 1 of 3 : UCIP\_SP\_2018\_39254\_60894.jpg

LM Start	10.69	Rating **	A/W	Issue No.	1229
LM End	10.69	Issue Type +	Ma	Location *	
Category	Supplemental			GPS Latitude/Longitude	
				Start	End
Item	DWR UCIP LMA Responsibility			37.283710 °	37.283710 °
				-120.833329 °	-120.833329 °
DWR ID					
Comment Code					
Inspector Comment					
FS_ID:39254 DS_ID:19631 EP_NO: N/A Repair Type: No Action Needed Crossing Status: Found UCIP Comments: FIELD_STRUCT_DESC: 24-inch corrugated metal gravity drainage pipe through the levee, 7 feet below the crown. Flap gate on the waterside (WS) end. Brass cap No. 67 bench mark (BM) on the headwall on the landside (LS). [Additional Reference(s): DWR Levee Log, 2002. USACE San Joaquin O&M Manual 601.1, 1967, (HLM 10.72)]. FS Date: 4/9/2014

Headwall, pipe, and flapgate on WS toe.

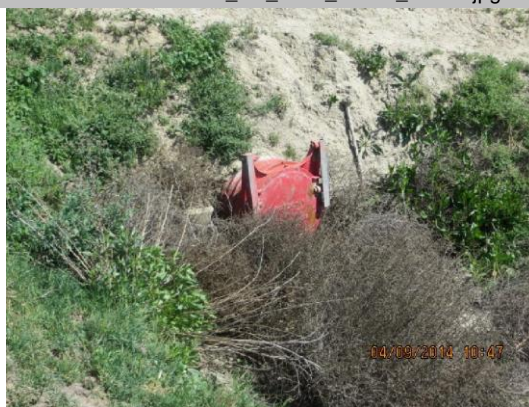
Photo 2 of 3 : UCIP\_SP\_2018\_39254\_60893.jpg

Headwall, pipe, and flapgate on WS toe.

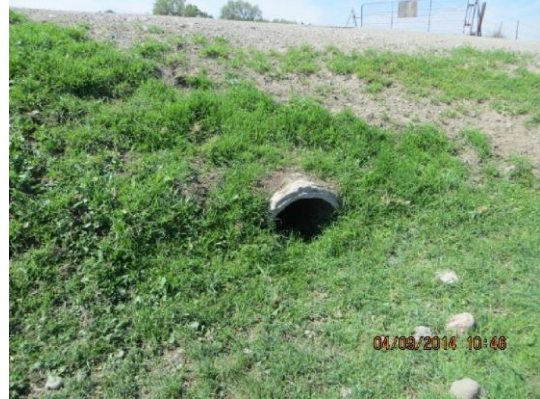
Photo 3 of 3 : UCIP\_SP\_2018\_39254\_60895.jpg

LM Start	10.69	Rating **	A/W	Issue No.	1229 (cont)	
LM End	10.69	Issue Type +	Ma	Location *		
Category	Supplemental			GPS Latitude/Longitude		
				Start	End	
Item	DWR UCIP LMA Responsibility			37.283710 °	37.283710 °	
				-120.833329 °	-120.833329 °	
DWR ID						
Comment Code						
Inspector Comment						
FS_ID:39254						
DS_ID:19631						
EP_NO: N/A						
Repair Type: No Action Needed						
Crossing Status: Found						
UCIP Comments:						
FIELD_STRUCT_DESC: 24-inch corrugated metal gravity drainage pipe						
through the levee, 7 feet below the crown. Flap gate on the waterside						
(WS) end. Brass cap No. 67 bench mark (BM) on the headwall on the						
landside (LS). [Additional Reference(s): DWR Levee Log, 2002. USACE						
San Joaquin O&M Manual 601.1, 1967, (HLM 10.72)].						
FS Date: 4/9/2014

Concrete pipe visible on LS slope.

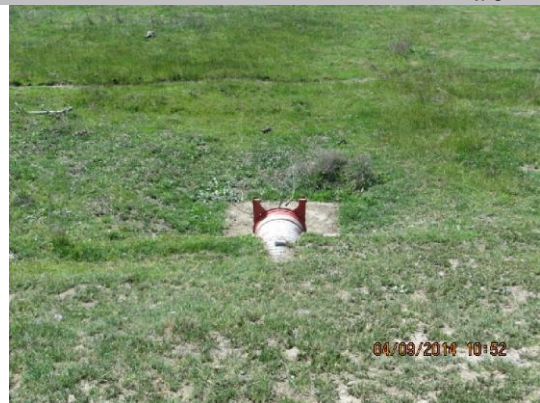
Photo 1 of 3 : UCIP\_SP\_2018\_39255\_60897.jpg

LM Start	10.98	Rating **	M	Issue No.	1230
LM End	10.98	Issue Type +	Ma	Location *	
Category	Supplemental			GPS Latitude/Longitude	
				Start	End
Item	DWR UCIP LMA Responsibility			37.282627 °	37.282627 °
				-120.828233 °	-120.828233 °
DWR ID					
Comment Code					
Inspector Comment					
FS_ID:39255 DS_ID:19632 EP_NO: N/A Repair Type: Non-Urgent Crossing Status: Found UCIP Comments: Dense vegetation blocks landward headwall. Recommend removing excess vegetation on landward toe. FIELD_STRUCT_DESC: 24-inch corrugated metal gravity drainage pipe through the levee, 6 feet below the crown. Flap gate on the waterside (WS) end. Brass cap No. 66 bench mark (BM) on the headwall on the landside (LS). [Additional Reference(s): DWR Levee Log, 2002. USACE San Joaquin O&M Manual 601.1, 1967, (HLM 11.00)]. FS Date: 4/9/2014

Pipe, headwall, and flapgate on WS toe.

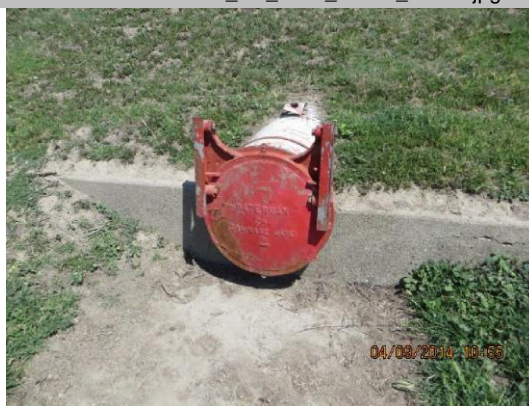
Photo 2 of 3 : UCIP\_SP\_2018\_39255\_60899.jpg

Item	DWR UCIP LMA Responsibility			37.282627 °		37.282627 °
				-120.828233 °		-120.828233 °
DWR ID						
Comment Code						
Inspector Comment						
FS_ID:39255						
DS_ID:19632						
EP_NO: N/A						
Repair Type: Non-Urgent						
Crossing Status: Found						
UCIP Comments: Dense vegetation blocks landward headwall.						
Recommend removing excess vegetation on landward toe.						
FIELD_STRUCT_DESC: 24-inch corrugated metal gravity drainage pipe						
through the levee, 6 feet below the crown. Flap gate on the waterside						
(WS) end. Brass cap No. 66 bench mark (BM) on the headwall on the						
landside (LS). [Additional Reference(s): DWR Levee Log, 2002. USACE						
San Joaquin O&M Manual 601.1, 1967, (HLM 11.00)].						
FS Date: 4/9/2014

Pipe, headwall, and flapgate on WS toe.

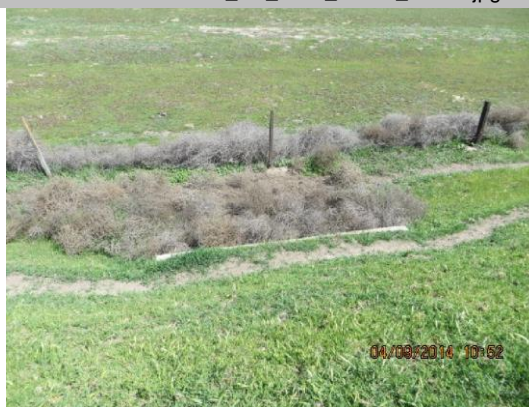
Photo 3 of 3 : UCIP\_SP\_2018\_39255\_60898.jpg

Pipe and headwall on LS toe.

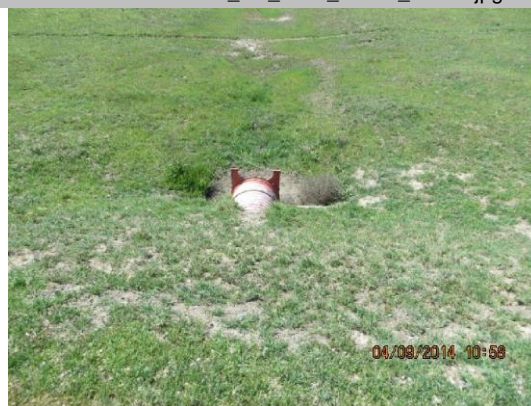
Photo 1 of 3 : UCIP\_SP\_2018\_33690\_60903.jpg

LM Start	11.14	Rating **	A/W	Issue No.	1231
LM End	11.14	Issue Type +	Ma	Location *	
Category	Supplemental			GPS Latitude/Longitude	
				Start	End
Item	DWR UCIP LMA Responsibility			37.281813 °	37.281813 °
				-120.825409 °	-120.825409 °
DWR ID					
Comment Code					
Inspector Comment					
FS_ID:33690 DS_ID:19633 EP_NO: N/A Repair Type: No Action Needed Crossing Status: Found UCIP Comments: FIELD_STRUCT_DESC: 24-inch corrugated metal gravity drainage pipe through the levee, 5 feet below the crown. Flap gate on the waterside (WS) end. Brass cap No. 65 bench mark (BM) on the headwall on the landside (LS). [Additional Reference(s): DWR Levee Log, 2002. USACE San Joaquin O&M Manual 601.1, 1967, (HLM 11.18)]. FS Date: 4/9/2014

Pipe, headwall, and flapgate on WS toe.

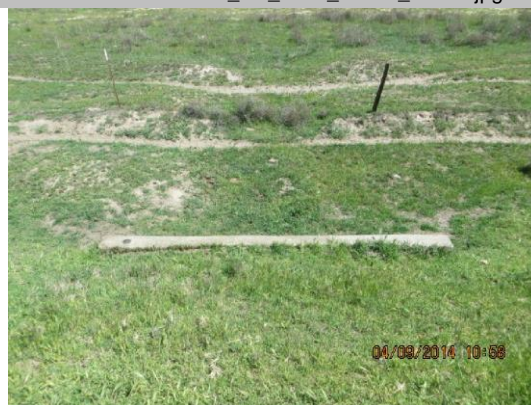
Photo 2 of 3 : UCIP\_SP\_2018\_33690\_60902.jpg

Pipe and headwall at LS toe.

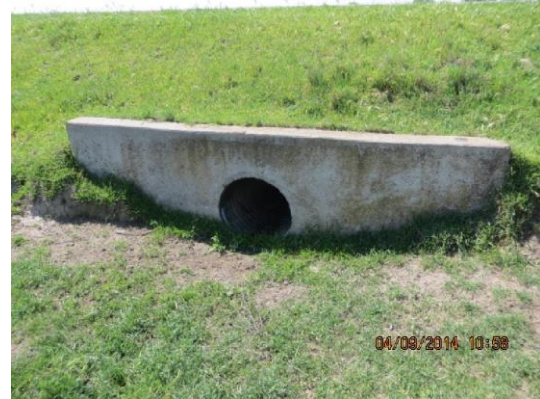
Photo 3 of 3 : UCIP\_SP\_2018\_33690\_60901.jpg

LM Start	11.14	Rating **	A/W	Issue No.	1231 (cont)	
LM End	11.14	Issue Type +	Ma	Location *		
Category	Supplemental			GPS Latitude/Longitude		
				Start	End	
Item	DWR UCIP LMA Responsibility			37.281813 °	37.281813 °	
				-120.825409 °	-120.825409 °	
DWR ID						
Comment Code						
Inspector Comment						
FS_ID:33690						
DS_ID:19633						
EP_NO: N/A						
Repair Type: No Action Needed						
Crossing Status: Found						
UCIP Comments:						
FIELD_STRUCT_DESC: 24-inch corrugated metal gravity drainage pipe						
through the levee, 5 feet below the crown. Flap gate on the waterside						
(WS) end. Brass cap No. 65 bench mark (BM) on the headwall on the						
landside (LS). [Additional Reference(s): DWR Levee Log, 2002. USACE						
San Joaquin O&M Manual 601.1, 1967, (HLM 11.18)].						
FS Date: 4/9/2014

Pipe and headwall at LS toe.

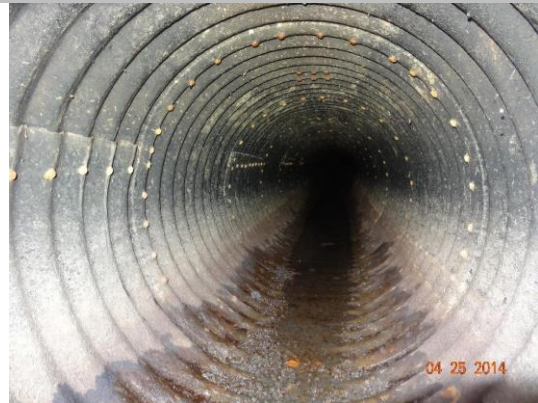
Photo 3 of 3 : UCIP\_SP\_2018\_36103\_65363.jpg

Item	DWR UCIP LMA Responsibility			37.273787 °	37.273787 °	
				-120.825519 °	-120.825519 °	
DWR ID						
Comment Code						
Inspector Comment						
FS_ID:36103						
DS_ID:19634						
EP_NO: N/A						
Repair Type: Non-Urgent						
Crossing Status: Found						
UCIP Comments: Need to contact owner--landward side has been buried. It appears that soil was removed from levee toe, immediately upstream, and used to pile soil at landward side at crossing.						
FIELD_STRUCT_DESC: 24-inch corrugated metal gravity drainage pipe through the levee, 10 feet below the crown. Flap gate on the waterside (WS) end. Brass cap No. 62 bench mark (BM) on the headwall on the landside (LS). [Additional Reference(s): DWR Levee Log, 2002. USACE San Joaquin O&M Manual 601.1, 1967, (HLM 11.48)].						
FS Date: 4/25/2014

Inside view of pipe from waterward side.

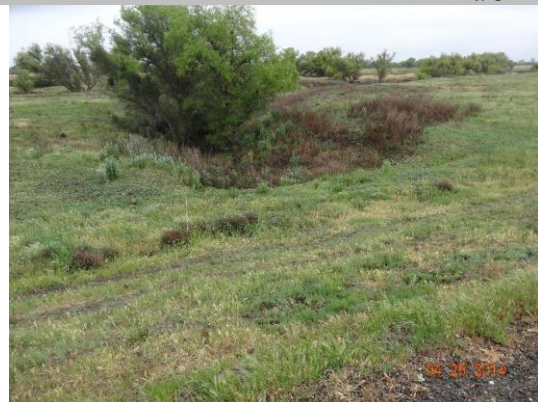
Photo 1 of 3 : UCIP\_SP\_2018\_36105\_65372.jpg

Comment Code						
Inspector Comment						
FS_ID:36105 DS_ID:19635 EP_NO: N/A Repair Type: Non-Urgent Crossing Status: Found UCIP Comments: Crossing is non-functional --landward side is buried. Debris found on landward side (channel). Dense vegetation found on waterward slope. Recommend contacting owner to determine status of crossing. If crossing is no longer used need to coordinate with CVFPB for proper abandonment. FIELD_STRUCT_DESC: 24-inch corrugated metal gravity drainage pipe through the levee, 17 feet below the crown. Flap gate on the waterside (WS) end. Brass cap No. 61 bench mark (BM) on the headwall on the landside (LS). [Additional Reference(s): DWR Levee Log, 2002. USACE San Joaquin O&M Manual 601.1, 1967, (HLM 11.76)]. FS Date: 4/25/2014

View of waterward side.

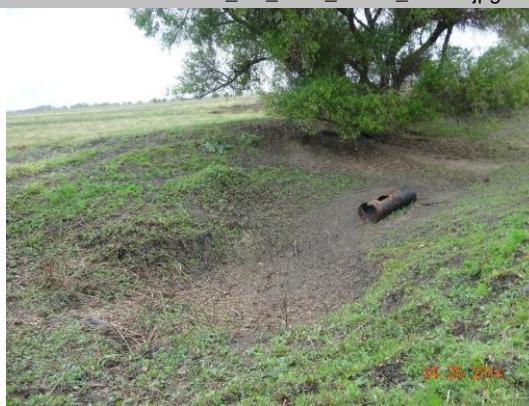
Photo 2 of 3 : UCIP\_SP\_2018\_36105\_65371.jpg

Item	DWR UCIP LMA Responsibility			37.269701 °	37.269701 °	
				-120.826450 °	-120.826450 °	
DWR ID						
Comment Code						
Inspector Comment						
FS_ID:36105 DS_ID:19635 EP_NO: N/A Repair Type: Non-Urgent Crossing Status: Found UCIP Comments: Crossing is non-functional --landward side is buried. Debris found on landward side (channel). Dense vegetation found on waterward slope. Recommend contacting owner to determine status of crossing. If crossing is no longer used need to coordinate with CVFPB for proper abandonment. FIELD_STRUCT_DESC: 24-inch corrugated metal gravity drainage pipe through the levee, 17 feet below the crown. Flap gate on the waterside (WS) end. Brass cap No. 61 bench mark (BM) on the headwall on the landside (LS). [Additional Reference(s): DWR Levee Log, 2002. USACE San Joaquin O&M Manual 601.1, 1967, (HLM 11.76)]. FS Date: 4/25/2014

Landward side of crossing buried--damage pipe section visible on landward side.

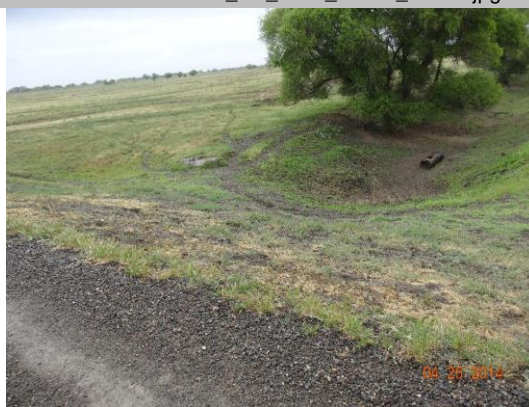
Photo 3 of 3 : UCIP\_SP\_2018\_36105\_65373.jpg

View of landward side.

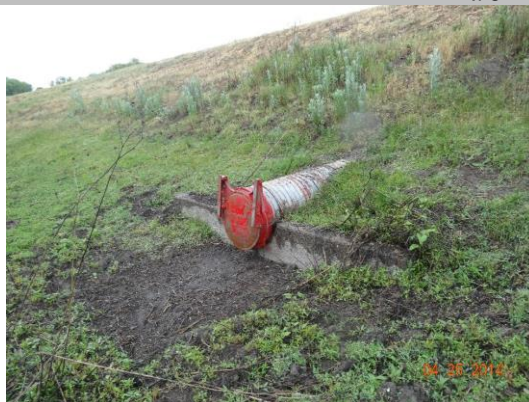
Photo 2 of 3 : UCIP\_SP\_2018\_36106\_65379.jpg

Comment Code					
Inspector Comment					
FS_ID:36106 DS_ID:19636 EP_NO: N/A Repair Type: Non-Urgent Crossing Status: Found UCIP Comments: Crossing is non-functional --landward side is buried. Dense vegetation found on waterward slope. Recommend contacting owner to determine status of crossing. If crossing is no longer used need to coordinate with CVFPB for proper abandonment. FIELD_STRUCT_DESC: 24-inch corrugated metal gravity drainage pipe through the levee, 12.4 feet below the crown. Flap gate on the waterside (WS) end. Brass cap No. 60 bench mark (BM) on the headwall on the landside (LS). [Additional Reference(s): DWR Levee Log, 2002. USACE San Joaquin O&M Manual 601.1, 1967, (HLM 12.11)]. FS Date: 4/25/2014

Flap gate and concrete headwall visible on waterward side.
