**Flood Control Project Maintenance  
Levee Inspections**  
**LMA District Cover Sheet**  
**Spring 2018 Levee Inspection Results**

**Lower San Joaquin Levee District**

**Spring 2018 Levee Inspection Results**

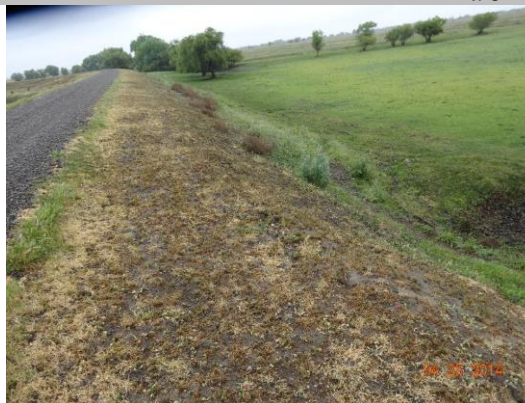
Photo 3 of 3 : UCIP\_SP\_2018\_36106\_65377.jpg

Comment Code					
Inspector Comment					
FS_ID:36106 DS_ID:19636 EP_NO: N/A Repair Type: Non-Urgent Crossing Status: Found UCIP Comments: Crossing is non-functional --landward side is buried. Dense vegetation found on waterward slope. Recommend contacting owner to determine status of crossing. If crossing is no longer used need to coordinate with CVFPB for proper abandonment. FIELD_STRUCT_DESC: 24-inch corrugated metal gravity drainage pipe through the levee, 12.4 feet below the crown. Flap gate on the waterside (WS) end. Brass cap No. 60 bench mark (BM) on the headwall on the landside (LS). [Additional Reference(s): DWR Levee Log, 2002. USACE San Joaquin O&M Manual 601.1, 1967, (HLM 12.11)]. FS Date: 4/25/2014

View of landward side.

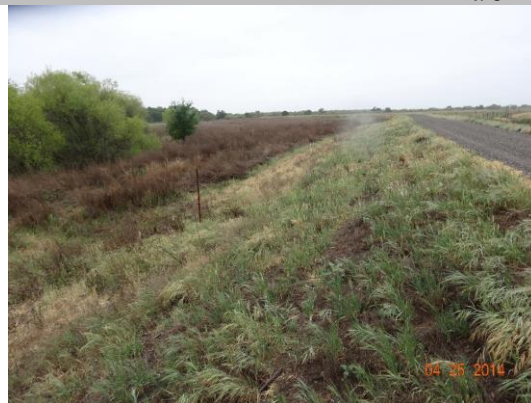
Photo 1 of 3 : UCIP\_SP\_2018\_36146\_65412.jpg

Comment Code					
Inspector Comment					
FS_ID:36146 DS_ID:19637 EP_NO: N/A Repair Type: Non-Urgent Crossing Status: Found UCIP Comments: Concrete headwall on landward side blocked by debris. Dense vegetation limits the inspector's visibility to identify signs of pipe failure (leaks) along the landward slope. Recommend removing vegetation along pipe alignment to conduct proper inspection of crossing. FIELD_STRUCT_DESC: 24-inch corrugated metal gravity drainage pipe through the levee, 9.5 feet below the crown. Flap gate on the waterside (WS) end. Brass cap No. 60 bench mark (BM) on the headwall on the landside (LS). [Additional Reference(s): DWR Levee Log, 2002. USACE San Joaquin O&M Manual 601.1, 1967, (HLM 12.94)]. FS Date: 4/25/2014

View of waterward side.

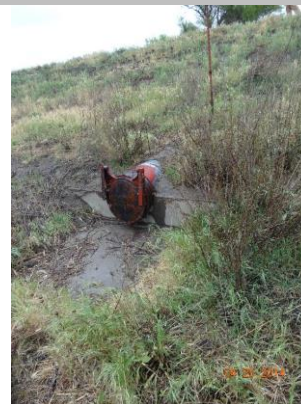
Photo 2 of 3 : UCIP\_SP\_2018\_36146\_65411.jpg

Flap gate and concrete headwall visible on waterward side.

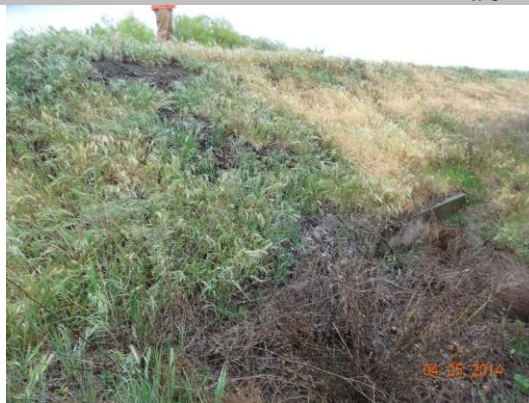
Photo 3 of 3 : UCIP\_SP\_2018\_36146\_65410.jpg

Item	DWR UCIP LMA Responsibility			37.256873 °	37.256873 °	
				-120.821277 °	-120.821277 °	
DWR ID						
Comment Code						
Inspector Comment						
FS_ID:36146						
DS_ID:19637						
EP_NO: N/A						
Repair Type: Non-Urgent						
Crossing Status: Found						
UCIP Comments: Concrete headwall on landward side blocked by debris. Dense vegetation limits the inspector's visibility to identify signs of pipe failure (leaks) along the landward slope. Recommend removing vegetation along pipe alignment to conduct proper inspection of crossing.						
FIELD_STRUCT_DESC: 24-inch corrugated metal gravity drainage pipe through the levee, 9.5 feet below the crown. Flap gate on the waterside (WS) end. Brass cap No. 60 bench mark (BM) on the headwall on the landside (LS). [Additional Reference(s): DWR Levee Log, 2002. USACE San Joaquin O&M Manual 601.1, 1967, (HLM 12.94)].						
FS Date: 4/25/2014

View of landward side--concrete headwall visible covered by dense vegetation.

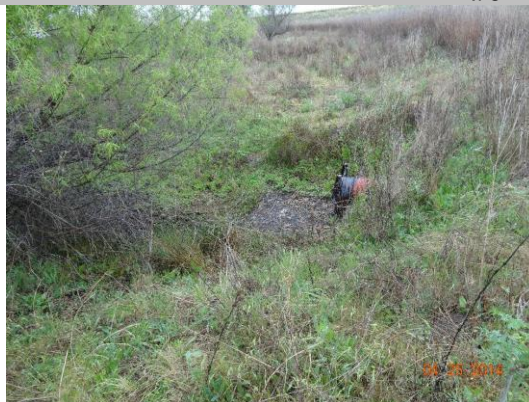
Photo 2 of 3 : UCIP\_SP\_2018\_36109\_65387.jpg

Comment Code					
Inspector Comment					
FS_ID:36109 DS_ID:19638 EP_NO: N/A Repair Type: Non-Urgent Crossing Status: Found UCIP Comments: Dense vegetation limits the inspector's visibility to identify signs of pipe failure (leaks) along the landward slope. Concrete headwall blocked by debris located on landward toe. Recommend clearing debris from landward slope and toe. FIELD_STRUCT_DESC: 24-inch corrugated metal gravity drainage pipe through the levee, 14.2 feet below the crown. Flap gate on the waterside (WS) end. Brass cap No. 60 bench mark (BM) on the headwall on the landside (LS). [Additional Reference(s): DWR Levee Log, 2002. USACE San Joaquin O&M Manual 601.1, 1967, (HLM 13.48)]. FS Date: 4/25/2014

View of flap gate and pipe through levee on waterward side.

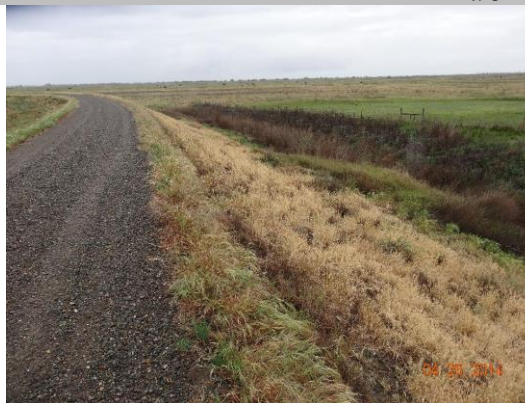
Photo 3 of 3 : UCIP\_SP\_2018\_36109\_65388.jpg

Item	DWR UCIP LMA Responsibility			37.251590 °		37.251590 °
				-120.814354 °		-120.814354 °
DWR ID						
Comment Code						
Inspector Comment						
FS_ID:36109						
DS_ID:19638						
EP_NO: N/A						
Repair Type: Non-Urgent						
Crossing Status: Found						
UCIP Comments: Dense vegetation limits the inspector's visibility to identify signs of pipe failure (leaks) along the landward slope. Concrete headwall blocked by debris located on landward toe. Recommend clearing debris from landward slope and toe.						
FIELD_STRUCT_DESC: 24-inch corrugated metal gravity drainage pipe through the levee, 14.2 feet below the crown. Flap gate on the waterside (WS) end. Brass cap No. 60 bench mark (BM) on the headwall on the landside (LS). [Additional Reference(s): DWR Levee Log, 2002. USACE San Joaquin O&M Manual 601.1, 1967, (HLM 13.48)].						
FS Date: 4/25/2014

View of landward side.

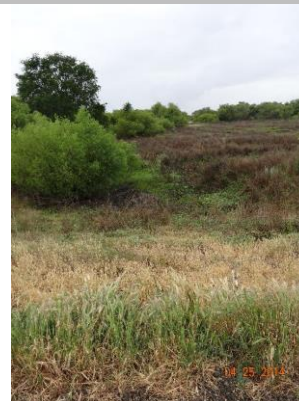
Photo 2 of 3 : UCIP\_SP\_2018\_39256\_65417.jpg

Comment Code						
Inspector Comment						
FS_ID:39256 DS_ID:19639 EP_NO: N/A Repair Type: Non-Urgent Crossing Status: Found UCIP Comments: No access to waterward toe due to fence. Unable to find the concrete headwall and flap gate on waterward side past fence. Also dense vegetation limits the inspector's visibility to identify signs of pipe failure (leaks) along the waterward slope. Recommend removing vegetation along pipe alignment to conduct proper inspection of structure. Also need access past fence on waterward side. FIELD_STRUCT_DESC: 24-inch corrugated metal gravity drainage pipe through the levee, 14.5 feet below the crown. Flap gate on the waterside (WS) end. Brass cap No. 60 bench mark (BM) on the headwall on the landside (LS). [Additional Reference(s): DWR Levee Log, 2002. USACE San Joaquin O&M Manual 601.1, 1967, (HLM 13.58)]. FS Date: 4/25/2014

Dense vegetation on waterward side.

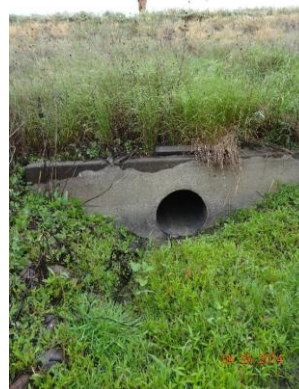
Photo 3 of 3 : UCIP\_SP\_2018\_39256\_65416.jpg

Item	DWR UCIP LMA Responsibility			37.250138 °		37.250138 °
				-120.814720 °		-120.814720 °
DWR ID						
Comment Code						
Inspector Comment						
FS_ID:39256 DS_ID:19639 EP_NO: N/A Repair Type: Non-Urgent Crossing Status: Found UCIP Comments: No access to waterward toe due to fence. Unable to find the concrete headwall and flap gate on waterward side past fence. Also dense vegetation limits the inspector's visibility to identify signs of pipe failure (leaks) along the waterward slope. Recommend removing vegetation along pipe alignment to conduct proper inspection of structure. Also need access past fence on waterward side. FIELD_STRUCT_DESC: 24-inch corrugated metal gravity drainage pipe through the levee, 14.5 feet below the crown. Flap gate on the waterside (WS) end. Brass cap No. 60 bench mark (BM) on the headwall on the landside (LS). [Additional Reference(s): DWR Levee Log, 2002. USACE San Joaquin O&M Manual 601.1, 1967, (HLM 13.58)]. FS Date: 4/25/2014

Concrete headwall visible from landward side.

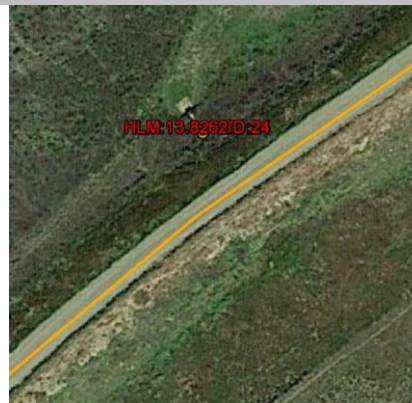
Photo 1 of 1 : UCIP\_SP\_2018\_36544\_66286.jpg

LM Start	13.82	Rating **	M	Issue No.	1239
LM End	13.82	Issue Type +	En	Location *	
Category	Supplemental			GPS Latitude/Longitude	
				Start	End
Item	DWR UCIP Field Study			37.247568 °	37.247568 °
				-120.817074 °	-120.817074 °
DWR ID					
Comment Code					
Inspector Comment					
FS_ID:36544 DS_ID:19640 EP_NO: N/A Repair Type: Non-Urgent Crossing Status: Indicator Found UCIP Comments: No photos available--missed crossing. Aerial photograph indicates crossing is present. Need to confirm if crossing is still present on waterward side. FIELD_STRUCT_DESC: 24-inch corrugated metal gravity drainage pipe through the levee, 11 feet below the crown. Flap gate on the waterside (WS) end. Brass cap No. 60 bench mark (BM) on the headwall on the landside (LS). [Additional Reference(s): DWR Levee Log, 2002. USACE San Joaquin O&M Manual 601.1, 1967, (HLM 13.81)]. FS Date: 4/25/2014

Indicators of crossing visible from aerial photograph.

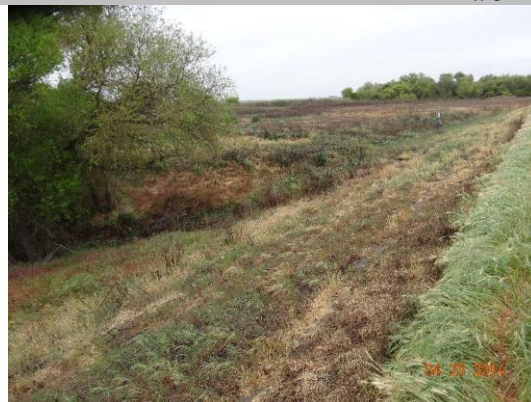
Photo 1 of 3 : UCIP\_SP\_2018\_36166\_65449.jpg

Comment Code					
Inspector Comment					
FS_ID:36166 DS_ID:19641 EP_NO: N/A Repair Type: Non-Urgent Crossing Status: Found UCIP Comments: Dense vegetation limits the inspector's visibility to identify signs of pipe failure (leaks) along the slopes. Recommend removing vegetation along pipe alignment to conduct proper inspection of structure. FIELD_STRUCT_DESC: 24-inch corrugated metal gravity drainage pipe through the levee, 13 feet below the crown. Flap gate on the waterside (WS) end. Brass cap No. 60 bench mark (BM) on the headwall on the landside (LS). [Additional Reference(s): DWR Levee Log, 2002. USACE San Joaquin O&M Manual 601.1, 1967, (HLM 14.21)]. FS Date: 4/25/2014

View of waterward side.

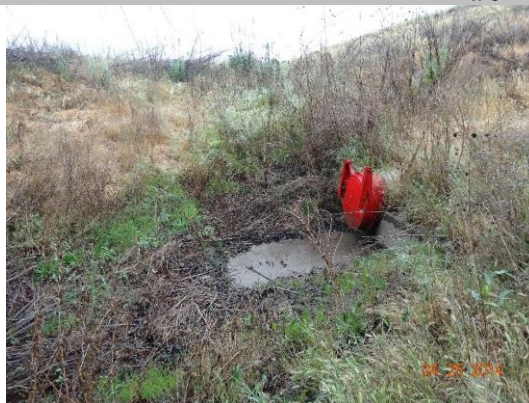
Photo 2 of 3 : UCIP\_SP\_2018\_36166\_65452.jpg

Item	DWR UCIP LMA Responsibility			37.242225 °	37.242225 °	
				-120.817665 °	-120.817665 °	
DWR ID						
Comment Code						
Inspector Comment						
FS_ID:36166 DS_ID:19641 EP_NO: N/A Repair Type: Non-Urgent Crossing Status: Found UCIP Comments: Dense vegetation limits the inspector's visibility to identify signs of pipe failure (leaks) along the slopes. Recommend removing vegetation along pipe alignment to conduct proper inspection of structure. FIELD_STRUCT_DESC: 24-inch corrugated metal gravity drainage pipe through the levee, 13 feet below the crown. Flap gate on the waterside (WS) end. Brass cap No. 60 bench mark (BM) on the headwall on the landside (LS). [Additional Reference(s): DWR Levee Log, 2002. USACE San Joaquin O&M Manual 601.1, 1967, (HLM 14.21)]. FS Date: 4/25/2014

View of concrete headwall, concrete apron, and flap gate on waterward side.

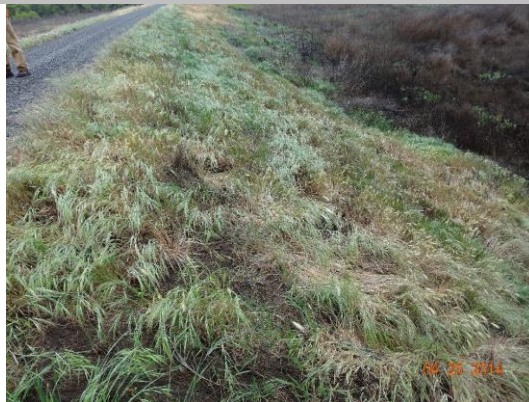
Photo 3 of 3 : UCIP\_SP\_2018\_36166\_65448.jpg

View of landward side.

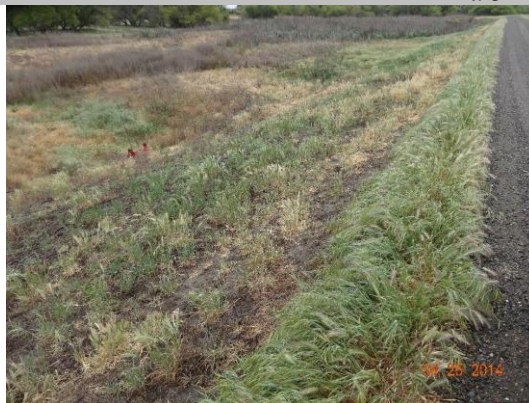
Photo 1 of 3 : UCIP\_SP\_2018\_36167\_65455.jpg

Comment Code					
Inspector Comment					
FS_ID:36167 DS_ID:19642 EP_NO: N/A Repair Type: Non-Urgent Crossing Status: Found UCIP Comments: Dense vegetation limits the inspector's visibility to identify signs of pipe failure (leaks) along the landward slope and toe. Recommend removing vegetation along pipe alignment to conduct proper inspection of structure. FIELD_STRUCT_DESC: 24-inch corrugated metal gravity drainage pipe through the levee, 9.7 feet below the crown. Flap gate on the waterside (WS) end. Brass cap No. 60 bench mark (BM) on the headwall on the landside (LS). [Additional Reference(s): DWR Levee Log, 2002. USACE San Joaquin O&M Manual 601.1, 1967, (HLM 14.65)]. FS Date: 4/25/2014

View of waterward side.

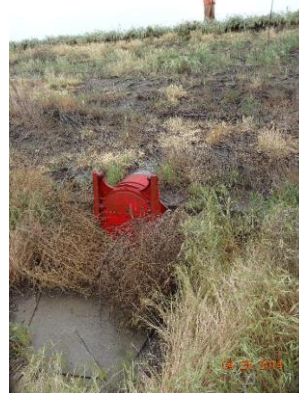
Photo 2 of 3 : UCIP\_SP\_2018\_36167\_65454.jpg

Flap gate, concrete headwall, and concrete apron located on waterward toe.

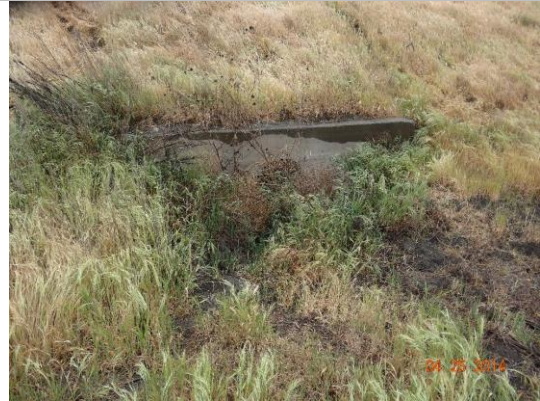
Photo 3 of 3 : UCIP\_SP\_2018\_36167\_65453.jpg

Item	DWR UCIP LMA Responsibility			37.237584 °	37.237584 °	
				-120.812967 °	-120.812967 °	
DWR ID						
Comment Code						
Inspector Comment						
FS_ID:36167 DS_ID:19642 EP_NO: N/A Repair Type: Non-Urgent Crossing Status: Found UCIP Comments: Dense vegetation limits the inspector's visibility to identify signs of pipe failure (leaks) along the landward slope and toe. Recommend removing vegetation along pipe alignment to conduct proper inspection of structure. FIELD_STRUCT_DESC: 24-inch corrugated metal gravity drainage pipe through the levee, 9.7 feet below the crown. Flap gate on the waterside (WS) end. Brass cap No. 60 bench mark (BM) on the headwall on the landside (LS). [Additional Reference(s): DWR Levee Log, 2002. USACE San Joaquin O&M Manual 601.1, 1967, (HLM 14.65)]. FS Date: 4/25/2014

Concrete headwall located on landward toe.

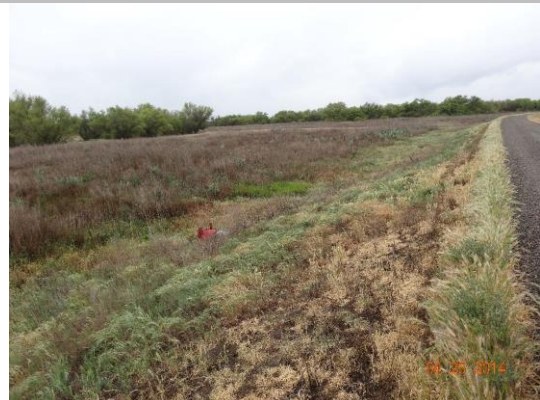
Photo 1 of 3 : UCIP\_SP\_2018\_36168\_65459.jpg

Comment Code						
Inspector Comment						
FS_ID:36168 DS_ID:19643 EP_NO: N/A Repair Type: Non-Urgent Crossing Status: Found UCIP Comments: Dense vegetation limits the inspector's visibility to identify signs of pipe failure (leaks) along the landward slope. Recommend removing vegetation along pipe alignment to conduct proper inspection of structure. FIELD_STRUCT_DESC: 24-inch corrugated metal gravity drainage pipe through the levee, 9.2 feet below the crown. Flap gate on the waterside (WS) end. Brass cap No. 60 bench mark (BM) on the headwall on the landside (LS). [Additional Reference(s): DWR Levee Log, 2002. USACE San Joaquin O&M Manual 601.1, 1967, (HLM 15.29)]. FS Date: 4/25/2014

View of waterward side.

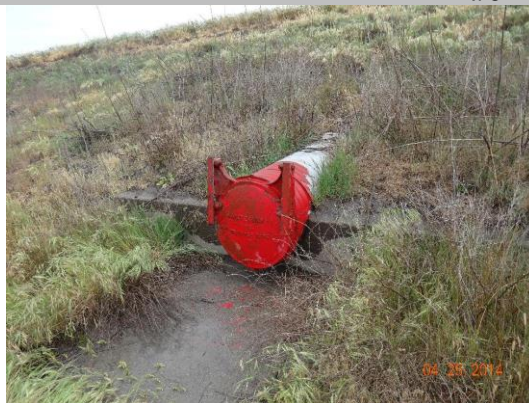
Photo 2 of 3 : UCIP\_SP\_2018\_36168\_65457.jpg

Item	DWR UCIP LMA Responsibility			37.231428 °	37.231428 °	
				-120.805543 °	-120.805543 °	
DWR ID						
Comment Code						
Inspector Comment						
FS_ID:36168 DS_ID:19643 EP_NO: N/A Repair Type: Non-Urgent Crossing Status: Found UCIP Comments: Dense vegetation limits the inspector's visibility to identify signs of pipe failure (leaks) along the landward slope. Recommend removing vegetation along pipe alignment to conduct proper inspection of structure. FIELD_STRUCT_DESC: 24-inch corrugated metal gravity drainage pipe through the levee, 9.2 feet below the crown. Flap gate on the waterside (WS) end. Brass cap No. 60 bench mark (BM) on the headwall on the landside (LS). [Additional Reference(s): DWR Levee Log, 2002. USACE San Joaquin O&M Manual 601.1, 1967, (HLM 15.29)]. FS Date: 4/25/2014

Concrete headwall, flap gate, and concrete apron located on waterward side.

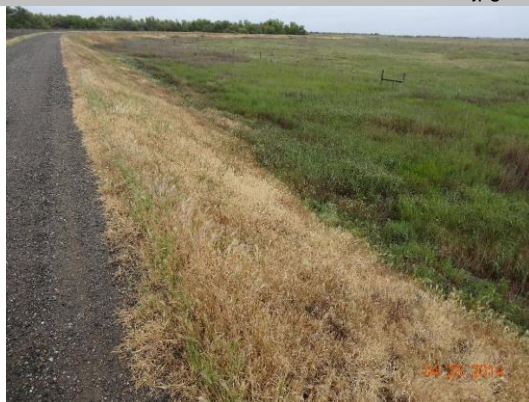
Photo 3 of 3 : UCIP\_SP\_2018\_36168\_65458.jpg

View of landward side.

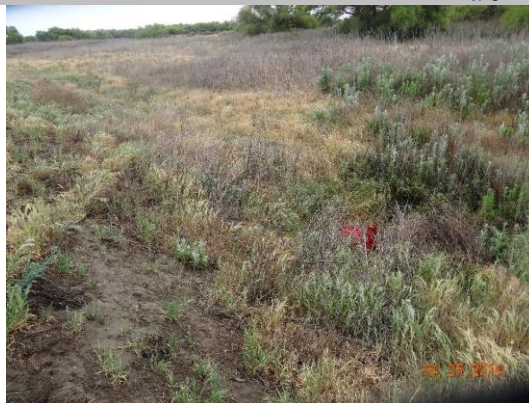
Photo 1 of 3 : UCIP\_SP\_2018\_36169\_65464.jpg

Comment Code					
Inspector Comment					
FS_ID:36169 DS_ID:19644 EP_NO: N/A Repair Type: Non-Urgent Crossing Status: Found UCIP Comments: Dense vegetation limits the inspector's visibility to identify signs of pipe failure (leaks) along the waterward and landward slopes. Recommend removing vegetation along pipe alignment to conduct proper inspection of structure. FIELD_STRUCT_DESC: 24-inch corrugated metal gravity drainage pipe through the levee, 8.5 feet below the crown. Flap gate on the waterside (WS) end. Brass cap No. 60 bench mark (BM) on the headwall on the landside (LS). [Additional Reference(s): DWR Levee Log, 2002. USACE San Joaquin O&M Manual 601.1, 1967, (HLM 15.57)]. FS Date: 4/25/2014

View of waterward side--flap gate visible through dense vegetation.

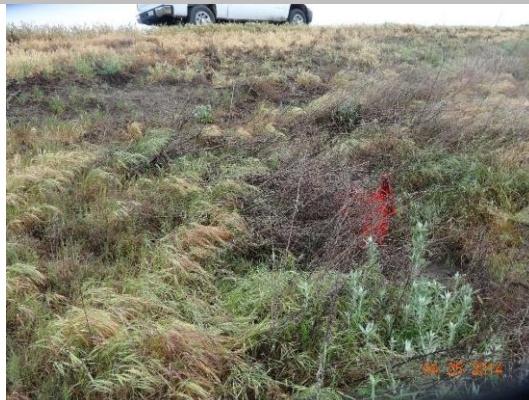
Photo 2 of 3 : UCIP\_SP\_2018\_36169\_65463.jpg

View of waterward slope covered by dense vegetation.

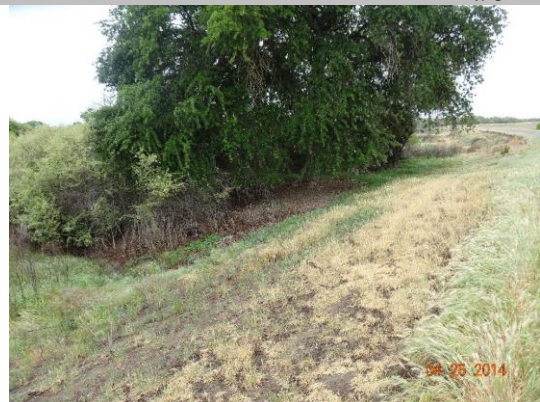
Photo 1 of 3 : UCIP\_SP\_2018\_36171\_65471.jpg

Comment Code						
Inspector Comment						
FS_ID:36171						
DS_ID:19645						
EP_NO: N/A						
Repair Type: Non-Urgent						
Crossing Status: Found						
UCIP Comments: Dense vegetation limits the inspector's visibility to identify signs of pipe failure (leaks) along the waterward and landward slope. Recommend removing vegetation along pipe alignment to conduct proper inspection of structure.						
FIELD_STRUCT_DESC: 24-inch corrugated metal gravity drainage pipe through the levee, 11 feet below the crown. Flap gate on the waterside (WS) end. Brass cap No. 60 bench mark (BM) on the headwall on the landside (LS). [Additional Reference(s): DWR Levee Log, 2002. USACE San Joaquin O&M Manual 601.1, 1967, (HLM 15.81)].						
FS Date: 4/25/2014

View of waterward side.

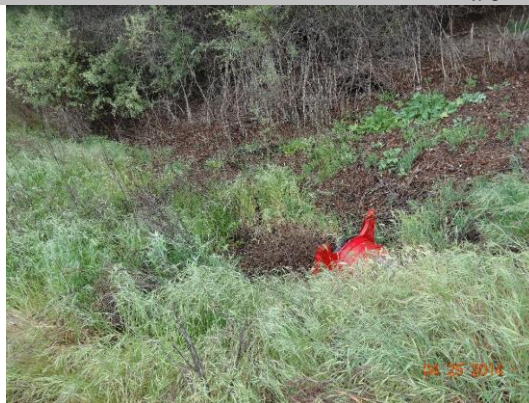
Photo 2 of 3 : UCIP\_SP\_2018\_36171\_65470.jpg

Item	DWR UCIP LMA Responsibility			37.226099 °		37.226099 °
				-120.799125 °		-120.799125 °
DWR ID						
Comment Code						
Inspector Comment						
FS_ID:36171 DS_ID:19645 EP_NO: N/A Repair Type: Non-Urgent Crossing Status: Found UCIP Comments: Dense vegetation limits the inspector's visibility to identify signs of pipe failure (leaks) along the waterward and landward slope. Recommend removing vegetation along pipe alignment to conduct proper inspection of structure. FIELD_STRUCT_DESC: 24-inch corrugated metal gravity drainage pipe through the levee, 11 feet below the crown. Flap gate on the waterside (WS) end. Brass cap No. 60 bench mark (BM) on the headwall on the landside (LS). [Additional Reference(s): DWR Levee Log, 2002. USACE San Joaquin O&M Manual 601.1, 1967, (HLM 15.81)]. FS Date: 4/25/2014

Flap gate visible on waterward side.

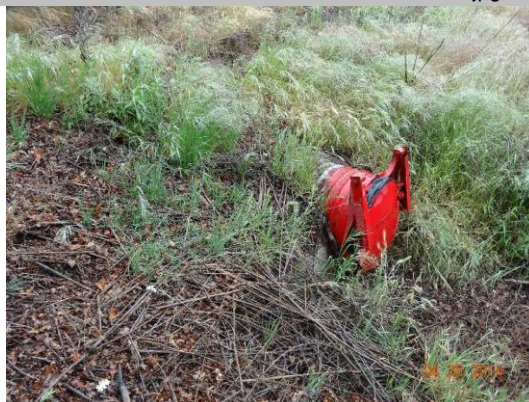
Photo 3 of 3 : UCIP\_SP\_2018\_36171\_65469.jpg

Side view of pipe and flap gate on waterward side.

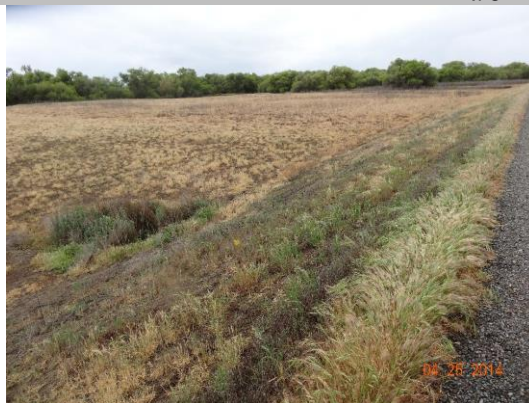
Photo 1 of 3 : UCIP\_SP\_2018\_36172\_65476.jpg

Comment Code					
Inspector Comment					
FS_ID:36172 DS_ID:19646 EP_NO: N/A Repair Type: Non-Urgent Crossing Status: Found UCIP Comments: Dense vegetation limits the inspector's visibility to identify signs of pipe failure (leaks) along the waterward and landward slopes. Recommend removing vegetation along pipe alignment to conduct proper inspection of structure and appurtenances. FIELD_STRUCT_DESC: 24-inch corrugated metal gravity drainage pipe through the levee, 11.3 feet below the crown. Flap gate on the waterside (WS) end. Brass cap No. 50 bench mark (BM) on the headwall on the landside (LS). [Additional Reference(s): DWR Levee Log, 2002. USACE San Joaquin O&M Manual 601.1, 1967, (HLM 16.09)]. FS Date: 4/25/2014

View of waterward side.

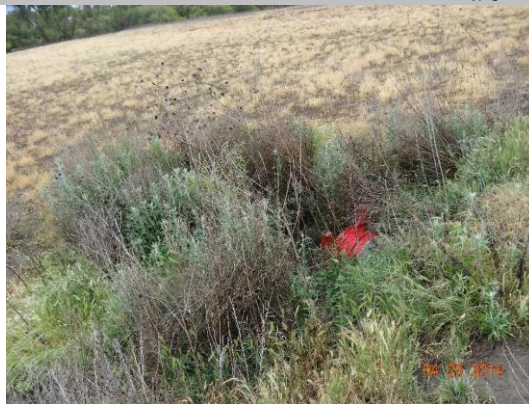
Photo 2 of 3 : UCIP\_SP\_2018\_36172\_65475.jpg

Flap gate visible on waterward toe.

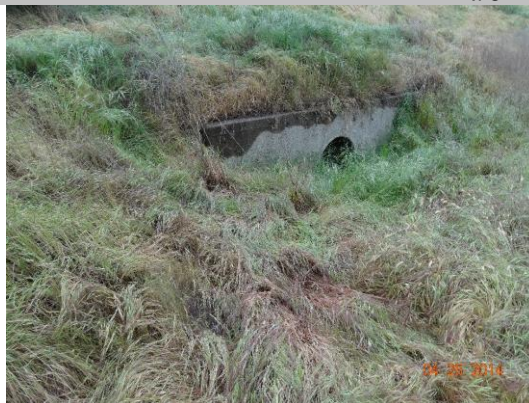
Photo 3 of 3 : UCIP\_SP\_2018\_36172\_65474.jpg

Item	DWR UCIP LMA Responsibility			37.224157 °		37.224157 °
				-120.795250 °		-120.795250 °
DWR ID						
Comment Code						
Inspector Comment						
FS_ID:36172						
DS_ID:19646						
EP_NO: N/A						
Repair Type: Non-Urgent						
Crossing Status: Found						
UCIP Comments: Dense vegetation limits the inspector's visibility to identify signs of pipe failure (leaks) along the waterward and landward slopes. Recommend removing vegetation along pipe alignment to conduct proper inspection of structure and appurtenances.						
FIELD_STRUCT_DESC: 24-inch corrugated metal gravity drainage pipe through the levee, 11.3 feet below the crown. Flap gate on the waterside (WS) end. Brass cap No. 50 bench mark (BM) on the headwall on the landside (LS). [Additional Reference(s): DWR Levee Log, 2002. USACE San Joaquin O&M Manual 601.1, 1967, (HLM 16.09)].						
FS Date: 4/25/2014

View of landward side.

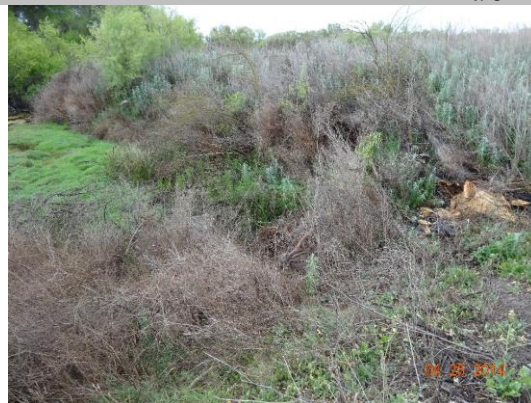
Photo 1 of 3 : UCIP\_SP\_2018\_39257\_65480.jpg

Comment Code					
Inspector Comment					
FS_ID:39257 DS_ID:19647 EP_NO: N/A Repair Type: Non-Urgent Crossing Status: Found UCIP Comments: Dense vegetation limits the inspector's visibility to identify signs of pipe failure (leaks) along the waterward and landward slopes. Recommend removing vegetation along pipe alignment to conduct proper inspection of structure. Unable to find pipe on landward side. FIELD_STRUCT_DESC: 24-inch corrugated metal gravity drainage pipe through the levee, 14.7 feet below the crown. Flap gate on the waterside (WS) end. Brass cap No. 50 bench mark (BM) on the headwall on the landside (LS). [Additional Reference(s): DWR Levee Log, 2002. USACE San Joaquin O&M Manual 601.1, 1967, (HLM 16.15)]. FS Date: 4/25/2014

View of waterward side.

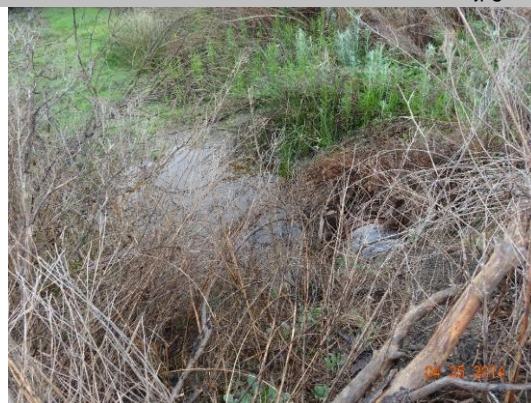
Photo 2 of 3 : UCIP\_SP\_2018\_39257\_65479.jpg

Crossing visible on waterward side under dense vegetation.

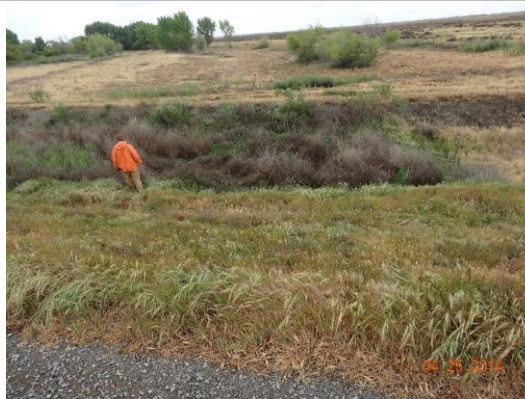
Photo 3 of 3 : UCIP\_SP\_2018\_39257\_65478.jpg

Item	DWR UCIP LMA Responsibility			37.224120 °		37.224120 °
				-120.794002 °		-120.794002 °
DWR ID						
Comment Code						
Inspector Comment						
FS_ID:39257						
DS_ID:19647						
EP_NO: N/A						
Repair Type: Non-Urgent						
Crossing Status: Found						
UCIP Comments: Dense vegetation limits the inspector's visibility to identify signs of pipe failure (leaks) along the waterward and landward slopes. Recommend removing vegetation along pipe alignment to conduct proper inspection of structure. Unable to find pipe on landward side.						
FIELD_STRUCT_DESC: 24-inch corrugated metal gravity drainage pipe through the levee, 14.7 feet below the crown. Flap gate on the waterside (WS) end. Brass cap No. 50 bench mark (BM) on the headwall on the landside (LS). [Additional Reference(s): DWR Levee Log, 2002. USACE San Joaquin O&M Manual 601.1, 1967, (HLM 16.15)].						
FS Date: 4/25/2014

View of landward side.

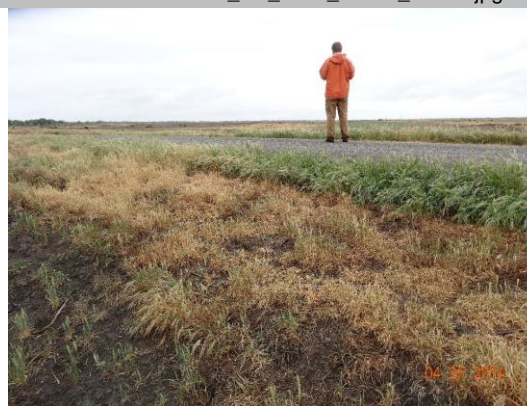
Photo 1 of 3 : UCIP\_SP\_2018\_39258\_66288.jpg

Comment Code					
Inspector Comment					
FS_ID:39258 DS_ID:19648 EP_NO: N/A Repair Type: Non-Urgent Crossing Status: Found UCIP Comments: Dense vegetation limits the inspector's visibility to identify signs of pipe failure (leaks) along the waterward and landward slopes. Recommend removing vegetation along pipe alignment to conduct proper inspection of structure. Unable to find pipe on landward side. FIELD_STRUCT_DESC: 24-inch corrugated metal gravity drainage pipe through the levee, 11.4 feet below the crown. Flap gate on the waterside (WS) end. Brass cap No. 50 bench mark (BM) on the headwall on the landside (LS). [Additional Reference(s): DWR Levee Log, 2002. USACE San Joaquin O&M Manual 601.1, 1967, (HLM 16.72)]. FS Date: 4/25/2014

View of levee crown at crossing.

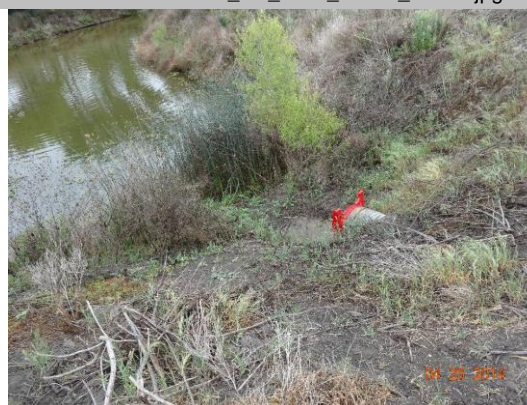
Photo 2 of 3 : UCIP\_SP\_2018\_39258\_66289.jpg

View of waterward side.

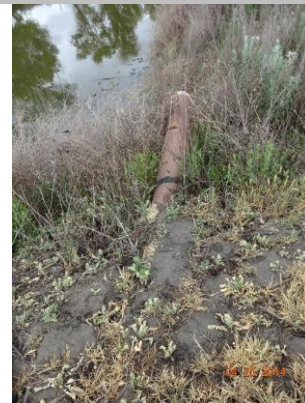
Photo 1 of 2 : UCIP\_SP\_2018\_39360\_71487.jpg

LM Start	16.72	Rating **	M	Issue No.	1248
LM End	16.72	Issue Type +	En	Location *	
Category	Supplemental			GPS Latitude/Longitude	
				Start	End
Item	DWR UCIP Field Study			37.224223 °	37.224223 °
				-120.783806 °	-120.783806 °
DWR ID					
Comment Code					
Inspector Comment					
FS_ID:39360 DS_ID:24870 EP_NO: N/A Repair Type: Non-Urgent Crossing Status: Found UCIP Comments: Need to contact owner to determine status and reason for crossing. FIELD_STRUCT_DESC: 12-inch steel gravity drainage pipe through the levee, at an unknown depth. Concrete standpipe visible on the landside (LS). This pipe was field discovered. FS Date: 4/25/2014

View of pipe located on waterward side.

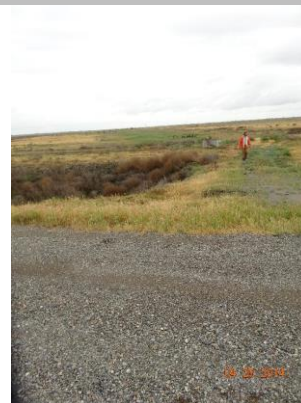
Photo 2 of 2 : UCIP\_SP\_2018\_39360\_71486.jpg

LM Start	16.72	Rating **	M	Issue No.	1248 (cont)	
LM End	16.72	Issue Type +	En	Location *		
Category	Supplemental			GPS Latitude/Longitude		
				Start	End	
Item	DWR UCIP Field Study			37.224223 °	37.224223 °	
				-120.783806 °	-120.783806 °	
DWR ID						
Comment Code						
Inspector Comment						
FS_ID:39360						
DS_ID:24870						
EP_NO: N/A						
Repair Type: Non-Urgent						
Crossing Status: Found						
UCIP Comments: Need to contact owner to determine status and reason for crossing.						
FIELD_STRUCT_DESC: 12-inch steel gravity drainage pipe through the levee, at an unknown depth. Concrete standpipe visible on the landside (LS). This pipe was field discovered.						
FS Date: 4/25/2014

View of landward side.

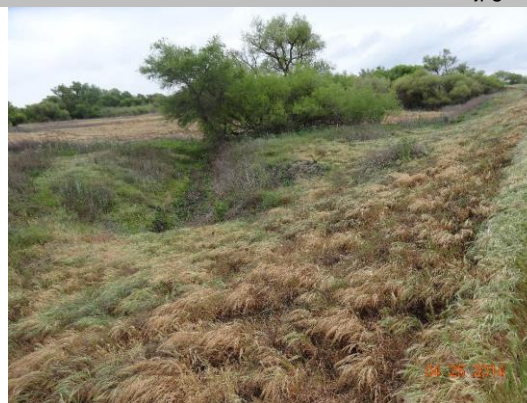
Photo 1 of 3 : UCIP\_SP\_2018\_39259\_65518.jpg

Comment Code						
Inspector Comment						
FS_ID:39259 DS_ID:19577 EP_NO: N/A Repair Type: Non-Urgent Crossing Status: Found UCIP Comments: Dense vegetation limits the inspector's visibility to identify signs of pipe failure (leaks) along the waterward and landward slopes. Concrete headwall is buried by dense vegetation. Recommend removing vegetation along pipe alignment to conduct proper inspection of structure. FIELD_STRUCT_DESC: 24-inch corrugated metal gravity drainage pipe through the levee, 11.5 feet below the crown. Flap gate on the waterside (WS) end. Brass cap No. 50 bench mark (BM) on the headwall on the landside (LS). [Additional Reference(s): DWR Levee Log, 2002. USACE San Joaquin O&M Manual 601.1, 1967, (HLM 17.01)]. FS Date: 4/25/2014

View of waterward side.

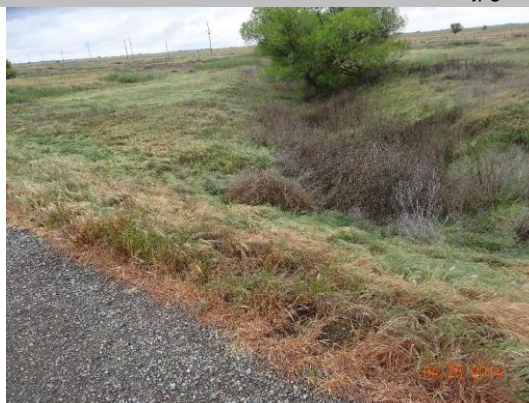
Photo 3 of 3 : UCIP\_SP\_2018\_39259\_65517.jpg

FS\_ID:39259  
DS\_ID:19577  
EP\_NO: N/A  
Repair Type: Non-Urgent  
Crossing Status: Found  
UCIP Comments: Dense vegetation limits the inspector's visibility to identify signs of pipe failure (leaks) along the waterward and landward slopes. Concrete headwall is buried by dense vegetation. Recommend removing vegetation along pipe alignment to conduct proper inspection of structure.  
FIELD\_STRUCT\_DESC: 24-inch corrugated metal gravity drainage pipe through the levee, 11.5 feet below the crown. Flap gate on the waterside (WS) end. Brass cap No. 50 bench mark (BM) on the headwall on the landside (LS). [Additional Reference(s): DWR Levee Log, 2002. USACE San Joaquin O&M Manual 601.1, 1967, (HLM 17.01)].  
FS Date: 4/25/2014

View of landward side.

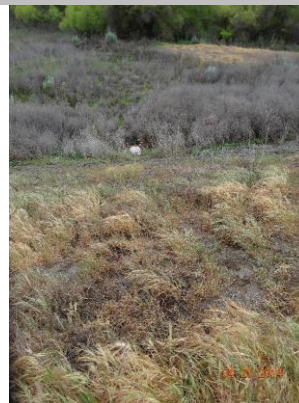
Photo 1 of 3 : UCIP\_SP\_2018\_39260\_65525.jpg

Comment Code						
Inspector Comment						
FS_ID:39260 DS_ID:19578 EP_NO: N/A Repair Type: Non-Urgent Crossing Status: Found UCIP Comments: Dense vegetation limits the inspector's visibility to identify signs of pipe failure (leaks) along the waterward and landward slopes. Recommend removing vegetation along pipe alignment to conduct proper inspection of structure. Sediment buildup inside pipe visible from landward side. Recommend clearing pipe. FIELD_STRUCT_DESC: 24-inch corrugated metal gravity drainage pipe through the levee, 11.5 feet below the crown. Flap gate on the waterside (WS) end. Brass cap No. 50 bench mark (BM) on the headwall on the landside (LS). [Additional Reference(s): DWR Levee Log, 2002. USACE San Joaquin O&M Manual 601.1, 1967, (HLM 17.19)]. FS Date: 4/25/2014

View of waterward side.

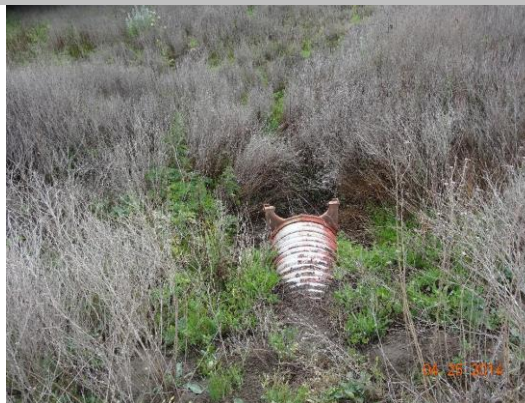
Photo 2 of 3 : UCIP\_SP\_2018\_39260\_65521.jpg

Pipe visible on waterward side.

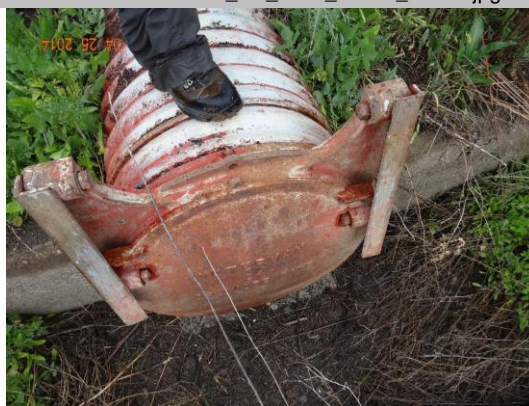
Photo 3 of 3 : UCIP\_SP\_2018\_39260\_65520.jpg

Item	DWR UCIP LMA Responsibility			37.219302 °		37.219302 °
				-120.779475 °		-120.779475 °
DWR ID						
Comment Code						
Inspector Comment						
FS_ID:39260 DS_ID:19578 EP_NO: N/A Repair Type: Non-Urgent Crossing Status: Found UCIP Comments: Dense vegetation limits the inspector's visibility to identify signs of pipe failure (leaks) along the waterward and landward slopes. Recommend removing vegetation along pipe alignment to conduct proper inspection of structure. Sediment buildup inside pipe visible from landward side. Recommend clearing pipe. FIELD_STRUCT_DESC: 24-inch corrugated metal gravity drainage pipe through the levee, 11.5 feet below the crown. Flap gate on the waterside (WS) end. Brass cap No. 50 bench mark (BM) on the headwall on the landside (LS). [Additional Reference(s): DWR Levee Log, 2002. USACE San Joaquin O&M Manual 601.1, 1967, (HLM 17.19)]. FS Date: 4/25/2014

Flap gate visible on waterward toe.

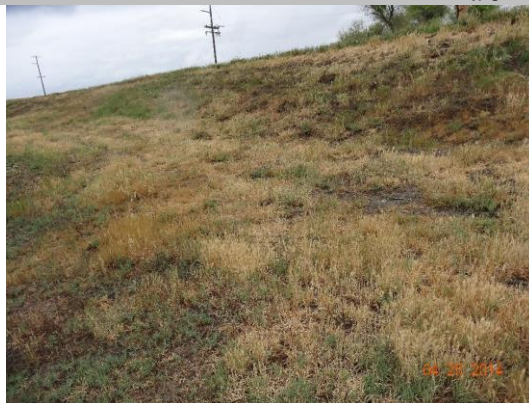
Photo 1 of 3 : UCIP\_SP\_2018\_36203\_65551.jpg

Comment Code					
Inspector Comment					
FS_ID:36203 DS_ID:19579 EP_NO: N/A Repair Type: Non-Urgent Crossing Status: Found UCIP Comments: Dense vegetation limits the inspector's visibility to identify signs of pipe failure (leaks) along the waterward and landward slope. Recommend removing vegetation along pipe alignment to conduct proper inspection of structure. FIELD_STRUCT_DESC: 24-inch corrugated metal gravity drainage pipe through the levee, 15.8 feet below the crown. Flap gate on the waterside (WS) end. Brass cap No. 50 bench mark (BM) on the headwall on the landside (LS). [Additional Reference(s): DWR Levee Log, 2002. USACE San Joaquin O&M Manual 601.1, 1967, (HLM 17.26)]. FS Date: 4/25/2014

View of waterward slope.

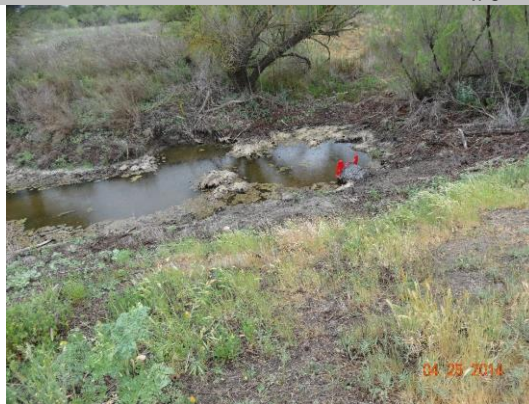
Photo 2 of 3 : UCIP\_SP\_2018\_36203\_65552.jpg

Pipe visible on waterward side.

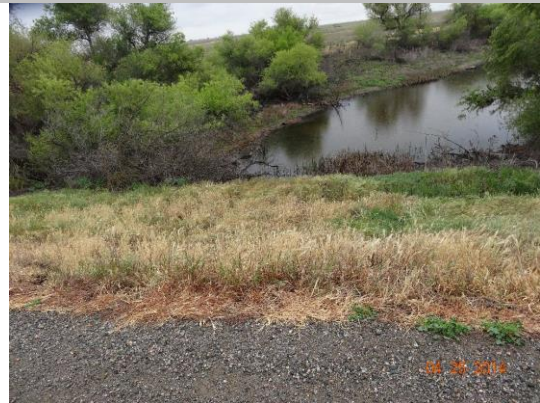
Photo 3 of 3 : UCIP\_SP\_2018\_36203\_65554.jpg

Item	DWR UCIP LMA Responsibility			37.218332 °		37.218332 °
				-120.779459 °		-120.779459 °
DWR ID						
Comment Code						
Inspector Comment						
FS_ID:36203 DS_ID:19579 EP_NO: N/A Repair Type: Non-Urgent Crossing Status: Found UCIP Comments: Dense vegetation limits the inspector's visibility to identify signs of pipe failure (leaks) along the waterward and landward slope. Recommend removing vegetation along pipe alignment to conduct proper inspection of structure. FIELD_STRUCT_DESC: 24-inch corrugated metal gravity drainage pipe through the levee, 15.8 feet below the crown. Flap gate on the waterside (WS) end. Brass cap No. 50 bench mark (BM) on the headwall on the landside (LS). [Additional Reference(s): DWR Levee Log, 2002. USACE San Joaquin O&M Manual 601.1, 1967, (HLM 17.26)]. FS Date: 4/25/2014

View of landward side.

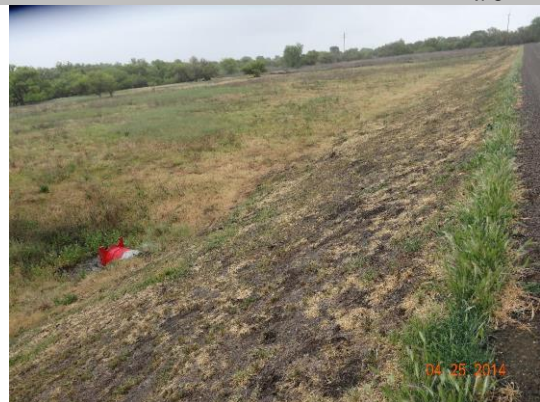
Photo 1 of 3 : UCIP\_SP\_2018\_36204\_65547.jpg

Comment Code						
Inspector Comment						
FS_ID:36204 DS_ID:19580 EP_NO: N/A Repair Type: Non-Urgent Crossing Status: Found UCIP Comments: Dense vegetation limits the inspector's visibility to identify signs of pipe failure (leaks) along the landward slope. Recommend removing vegetation along pipe alignment to conduct proper inspection of structure. FIELD_STRUCT_DESC: 24-inch corrugated metal gravity drainage pipe through the levee, 9.5 feet below the crown. Flap gate on the waterside (WS) end. Brass cap No. 50 bench mark (BM) on the headwall on the landside (LS). [Additional Reference(s): DWR Levee Log, 2002. USACE San Joaquin O&M Manual 601.1, 1967, (HLM 17.53)]. FS Date: 4/25/2014

View of waterward side.

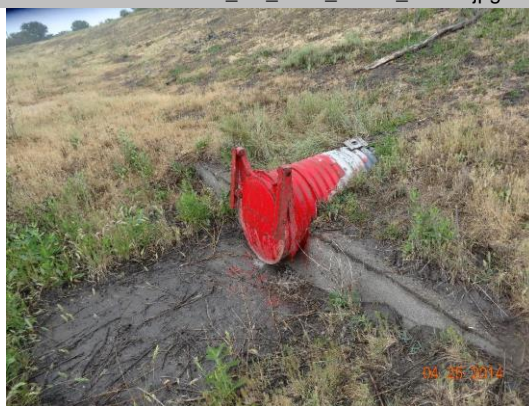
Photo 2 of 3 : UCIP\_SP\_2018\_36204\_65546.jpg

Item	DWR UCIP LMA Responsibility			37.215976 °	37.215976 °	
				-120.777615 °	-120.777615 °	
DWR ID						
Comment Code						
Inspector Comment						
FS_ID:36204 DS_ID:19580 EP_NO: N/A Repair Type: Non-Urgent Crossing Status: Found UCIP Comments: Dense vegetation limits the inspector's visibility to identify signs of pipe failure (leaks) along the landward slope. Recommend removing vegetation along pipe alignment to conduct proper inspection of structure. FIELD_STRUCT_DESC: 24-inch corrugated metal gravity drainage pipe through the levee, 9.5 feet below the crown. Flap gate on the waterside (WS) end. Brass cap No. 50 bench mark (BM) on the headwall on the landside (LS). [Additional Reference(s): DWR Levee Log, 2002. USACE San Joaquin O&M Manual 601.1, 1967, (HLM 17.53)]. FS Date: 4/25/2014

Flap gate visible on waterward side.

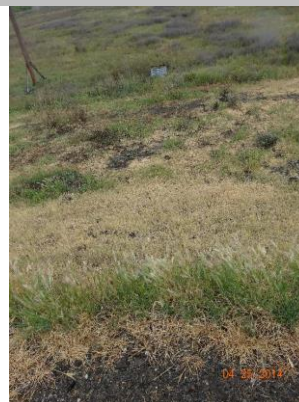
Photo 3 of 3 : UCIP\_SP\_2018\_36204\_65545.jpg

View of landward side--riser at levee toe.

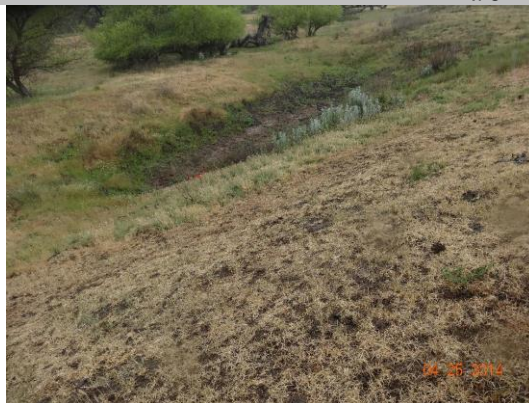
Photo 1 of 3 : UCIP\_SP\_2018\_39261\_65557.jpg

Comment Code						
Inspector Comment						
FS_ID:39261						
DS_ID:19581						
EP_NO: N/A						
Repair Type: Non-Urgent						
Crossing Status: Found						
UCIP Comments: Need to contact owner. Recommend investigating integrity of pipe wall through levee heavy corrosion visible from landward side.						
FIELD_STRUCT_DESC: 24-inch corrugated metal gravity drainage pipe through the levee, 11.5 feet below the crown. Flap gate on the waterside (WS) end. Brass cap No. 50 bench mark (BM) on the headwall on the landside (LS). [Additional Reference(s): DWR Levee Log, 2002. USACE San Joaquin O&M Manual 601.1, 1967, (HLM 18.19)].						
FS Date: 4/25/2014

View of waterward side.

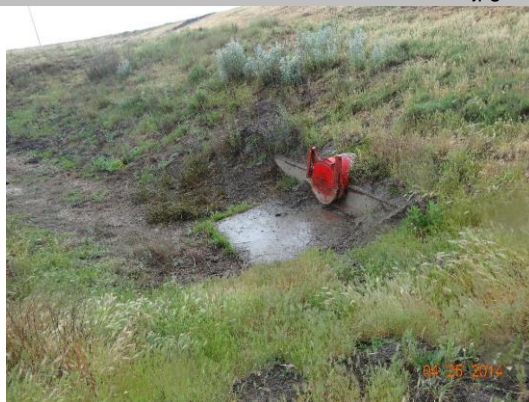
Photo 2 of 3 : UCIP\_SP\_2018\_39261\_65556.jpg

Flap gate visible on waterward side.

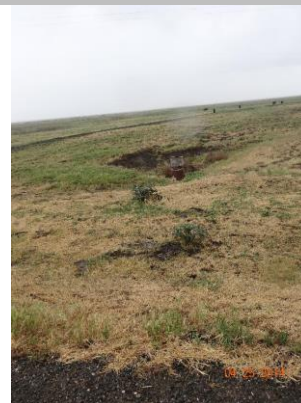
Photo 3 of 3 : UCIP\_SP\_2018\_39261\_65555.jpg

LM Start	18.18	Rating **	M	Issue No.	1253 (cont)	
LM End	18.18	Issue Type +	Ma	Location *		
Category	Supplemental			GPS Latitude/Longitude		
				Start		End
Item	DWR UCIP LMA Responsibility			37.210998 °	37.210998 °	
				-120.768900 °	-120.768900 °	
DWR ID						
Comment Code						
Inspector Comment						
FS_ID:39261 DS_ID:19581 EP_NO: N/A Repair Type: Non-Urgent Crossing Status: Found UCIP Comments: Need to contact owner. Recommend investigating integrity of pipe wall through levee heavy corrosion visible from landward side. FIELD_STRUCT_DESC: 24-inch corrugated metal gravity drainage pipe through the levee, 11.5 feet below the crown. Flap gate on the waterside (WS) end. Brass cap No. 50 bench mark (BM) on the headwall on the landside (LS). [Additional Reference(s): DWR Levee Log, 2002. USACE San Joaquin O&M Manual 601.1, 1967, (HLM 18.19)]. FS Date: 4/25/2014

View of landward side.

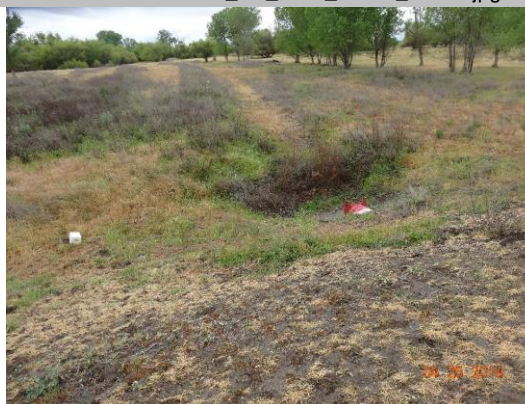
Photo 1 of 3 : UCIP\_SP\_2018\_36206\_65563.jpg

LM Start	18.45	Rating **	A/W	Issue No.	1254
LM End	18.45	Issue Type +	Ma	Location *	
Category	Supplemental			GPS Latitude/Longitude	
				Start	End
Item	DWR UCIP LMA Responsibility			37.207538 °	37.207538 °
				-120.767679 °	-120.767679 °
DWR ID					
Comment Code					
Inspector Comment					
FS_ID:36206					
DS_ID:19582					
EP_NO: N/A					
Repair Type: No Action Needed					
Crossing Status: Found					
UCIP Comments:					
FIELD_STRUCT_DESC: 24-inch corrugated metal gravity drainage pipe through the levee, 9.4 feet below the crown. Flap gate on the waterside (WS) end. Brass cap No. 50 bench mark (BM) on the headwall on the landside (LS). [Additional Reference(s): DWR Levee Log, 2002. USACE San Joaquin O&M Manual 601.1, 1967, (HLM 18.45)].					
FS Date: 4/25/2014

View of waterward side.

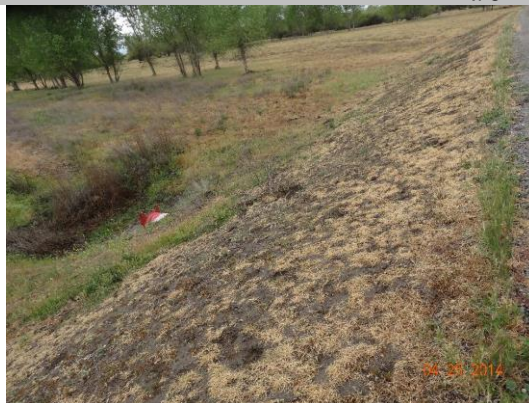
Photo 2 of 3 : UCIP\_SP\_2018\_36206\_65562.jpg

LM Start	18.45	Rating **	A/W	Issue No.	1254 (cont)	
LM End	18.45	Issue Type +	Ma	Location *		
Category	Supplemental			GPS Latitude/Longitude		
				Start	End	
Item	DWR UCIP LMA Responsibility			37.207538 °	37.207538 °	
				-120.767679 °	-120.767679 °	
DWR ID						
Comment Code						
Inspector Comment						
FS_ID:36206						
DS_ID:19582						
EP_NO: N/A						
Repair Type: No Action Needed						
Crossing Status: Found						
UCIP Comments:						
FIELD_STRUCT_DESC: 24-inch corrugated metal gravity drainage pipe						
through the levee, 9.4 feet below the crown. Flap gate on the waterside						
(WS) end. Brass cap No. 50 bench mark (BM) on the headwall on the						
landside (LS). [Additional Reference(s): DWR Levee Log, 2002. USACE						
San Joaquin O&M Manual 601.1, 1967, (HLM 18.45)].						
FS Date: 4/25/2014

View of waterward slope.

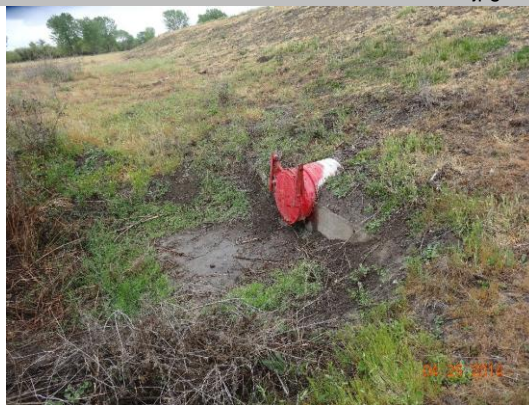
Photo 3 of 3 : UCIP\_SP\_2018\_36206\_65561.jpg

Flap gate visible on waterward side.

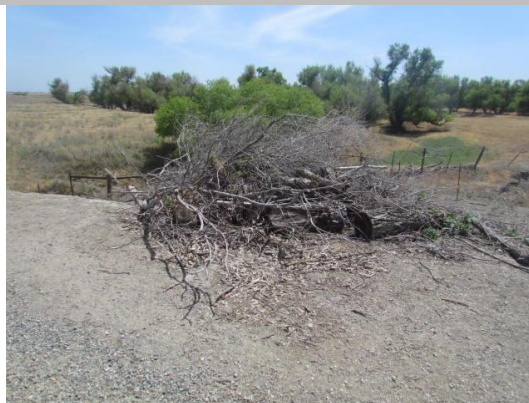
Photo 1 of 1 : SP\_2018\_NA0010\_118\_27\_20180307\_00016.jpg

LM Start	18.77	Rating **	M	Issue No.	27
LM End	18.77	Issue Type +	En	Location *	WS
Category	Earthen Levee			GPS Latitude/Longitude	
				Start	End
Item	Encroachments			37.205080 °	37.205080 °
				-120.762655 °	-120.762655 °
DWR ID	DWR_NA0010_01_s_2014_27				
Comment Code					
PR : Prunings					
Inspector Comment

Looking at prunings on waterward shoulder and slope.

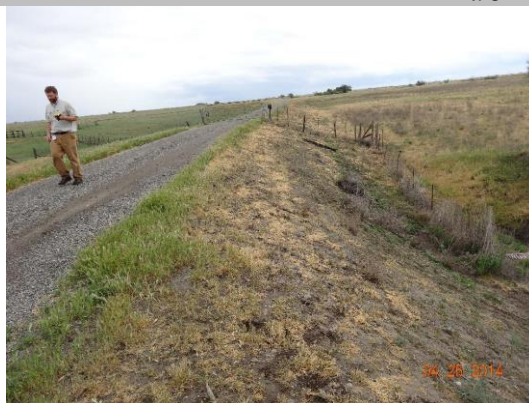
Photo 1 of 3 : UCIP\_SP\_2018\_36246\_65627.jpg

Comment Code						
Inspector Comment						
FS_ID:36246 DS_ID:19593 EP_NO: N/A Repair Type: Non-Urgent Crossing Status: Found UCIP Comments: Dense vegetation limits the inspector's visibility to identify signs of pipe failure (leaks) along the landward slope. Recommend removing vegetation along pipe alignment to conduct proper inspection of structure. FIELD_STRUCT_DESC: 24-inch corrugated metal gravity drainage pipe through the levee, 12 feet below the crown. Flap gate on the waterside (WS) end. Brass cap No. 50 bench mark (BM) on the headwall on the landside (LS). [Additional Reference(s): DWR Levee Log, 2002. USACE San Joaquin O&M Manual 601.1, 1967, (HLM 18.79)]. FS Date: 4/25/2014

Overview of levee crown and waterward slope.

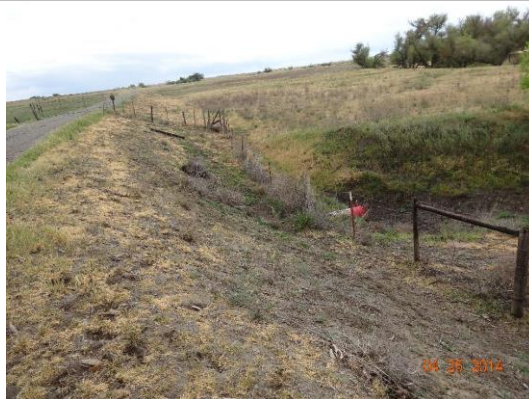
Photo 2 of 3 : UCIP\_SP\_2018\_36246\_65623.jpg

Item	DWR UCIP LMA Responsibility			37.204966 °	37.204966 °	
				-120.762511 °	-120.762511 °	
DWR ID						
Comment Code						
Inspector Comment						
FS_ID:36246 DS_ID:19593 EP_NO: N/A Repair Type: Non-Urgent Crossing Status: Found UCIP Comments: Dense vegetation limits the inspector's visibility to identify signs of pipe failure (leaks) along the landward slope. Recommend removing vegetation along pipe alignment to conduct proper inspection of structure. FIELD_STRUCT_DESC: 24-inch corrugated metal gravity drainage pipe through the levee, 12 feet below the crown. Flap gate on the waterside (WS) end. Brass cap No. 50 bench mark (BM) on the headwall on the landside (LS). [Additional Reference(s): DWR Levee Log, 2002. USACE San Joaquin O&M Manual 601.1, 1967, (HLM 18.79)]. FS Date: 4/25/2014

View of waterward side.

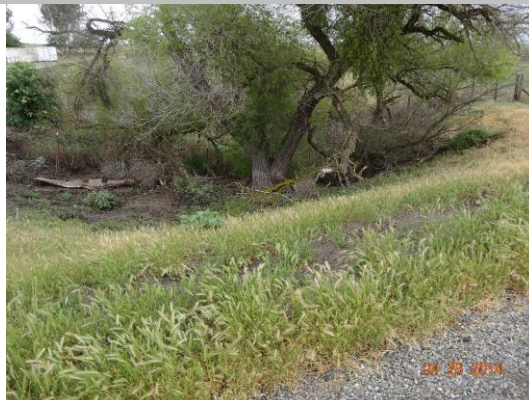
Photo 3 of 3 : UCIP\_SP\_2018\_36246\_65626.jpg

Overview of landward side.

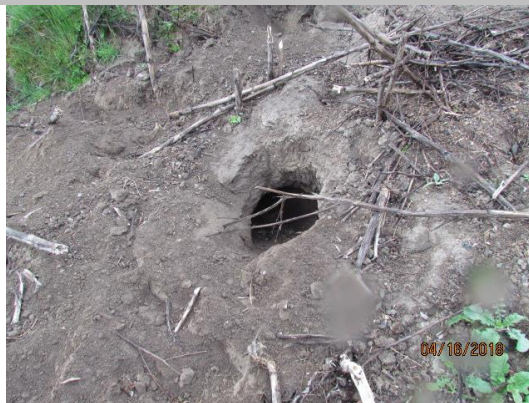
Photo 1 of 2 : SP\_2018\_NA0010\_118\_94\_20180420\_00274.jpg

LM Start	<b>18.79</b>	Rating **	U	Issue No.	<b>94 (cont)</b>
LM End	<b>18.79</b>	Issue Type +	Ma	Location *	LS

Looking at large rodent hole on landward slope. (Spring 2018)

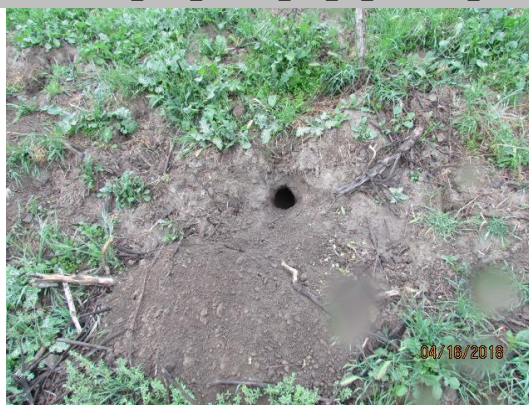
Photo 2 of 2 : SP\_2018\_NA0010\_118\_94\_20180420\_00275.jpg

Looking at typical view of rodent holes with this section. (Spring 2018)

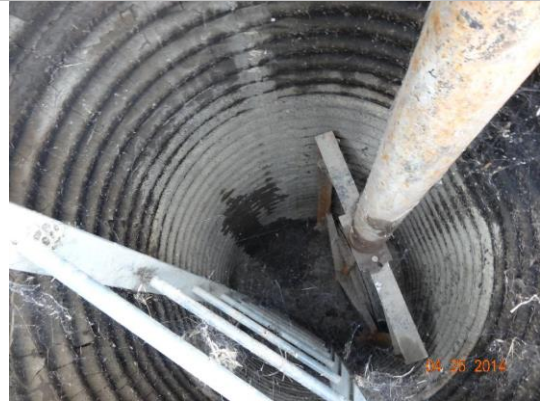
Photo 3 of 3 : UCIP\_SP\_2018\_39263\_65632.jpg

Item	DWR UCIP LMA Responsibility			37.202801 °		37.202801 °
				-120.756209 °		-120.756209 °
DWR ID						
Comment Code						
Inspector Comment						
FS_ID:39263						
DS_ID:19594						
EP_NO: N/A						
Repair Type: Non-Urgent						
Crossing Status: Found						
UCIP Comments: Non-functional crossing--pipe is buried on waterward side. Sediment buildup in pipe visible from landward side. Need to coordinate with owner to determine status. If crossing is no longer in use, owner will need to coordinate with DWR Inspector and CVFPB to properly abandon.						
FIELD_STRUCT_DESC: 24-inch corrugated metal gravity drainage pipe through the levee, 13 feet below the crown. Flap gate on the waterside (WS) end. Brass cap No. 40 bench mark (BM) on the headwall on the landside (LS). [Additional Reference(s): DWR Levee Log, 2002. USACE San Joaquin O&M Manual 601.1, 1967, (HLM 19.17)].						
FS Date: 4/25/2014

Inside view of CMP riser.

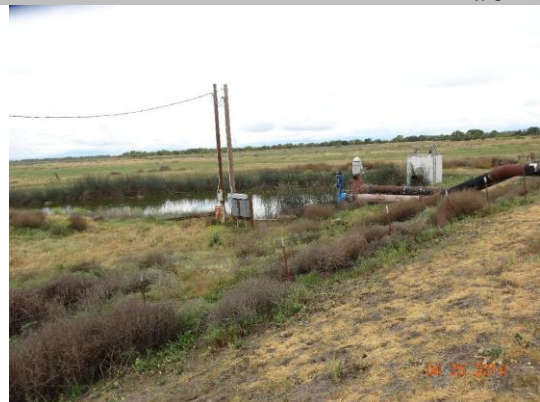
Photo 1 of 3 : UCIP\_SP\_2018\_39266\_71421.jpg

LM Start	19.32	Rating **	M	Issue No.	1257
LM End	19.32	Issue Type +	En	Location *	
Category	Supplemental			GPS Latitude/Longitude	
				Start	End
Item	DWR UCIP Field Study			37.200921 °	37.200921 °
				-120.756901 °	-120.756901 °
DWR ID					
Comment Code					
Inspector Comment					
FS_ID:39266					
DS_ID:24871					
EP_NO: N/A					
Repair Type: Non-Urgent					
Crossing Status: Found					
UCIP Comments: New crossing found during field inspection--Need to contact owner to obtain additional information about crossing.					
FIELD_STRUCT_DESC: 1 of 2: 20-inch steel drainage discharge pipe through the levee, at an unknown depth. Pump station and electrical panel on the landside (LS). This pipe was field discovered.					
FS Date: 4/25/2014

View of landward side.

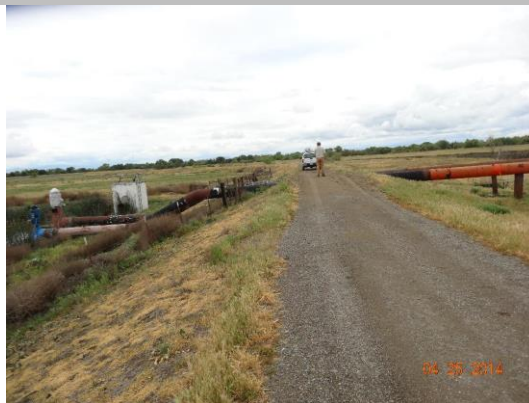
Photo 2 of 3 : UCIP\_SP\_2018\_39267\_71425.jpg

View of levee crown at crossings.
