**Flood Control Project Maintenance  
Levee Inspections**  
**LMA District Cover Sheet**  
**Spring 2018 Levee Inspection Results**

**Lower San Joaquin Levee District**

**Spring 2018 Levee Inspection Results**

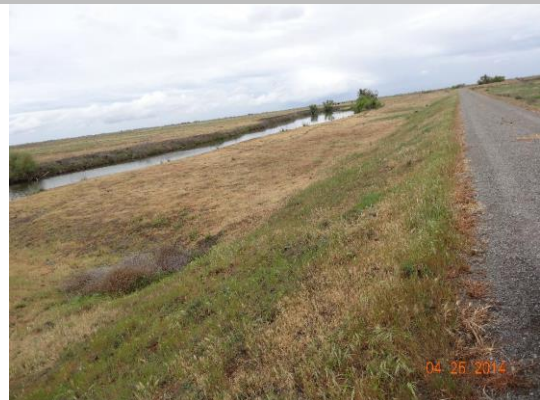
Photo 1 of 3 : UCIP\_SP\_2018\_39268\_65641.jpg

Comment Code					
Inspector Comment					
FS_ID:39268 DS_ID:19596 EP_NO: N/A Repair Type: Non-Urgent Crossing Status: Found UCIP Comments: Dense vegetation limits the inspector's visibility to identify signs of pipe failure (leaks) along the waterward slope. Recommend removing vegetation along pipe alignment to conduct proper inspection of structure. Dense vegetation blocks both waterward and landward headwalls. Sediment buildup in pipe visible from landward side. FIELD_STRUCT_DESC: 24-inch corrugated metal gravity drainage pipe through the levee, 8 feet below the crown. Flap gate on the waterside (WS) end. Brass cap No. 40 bench mark (BM) on the headwall on the landside (LS). [Additional Reference(s): DWR Levee Log, 2002. USACE San Joaquin O&M Manual 601.1, 1967, (HLM 19.54)]. FS Date: 4/25/2014

View of waterward side.

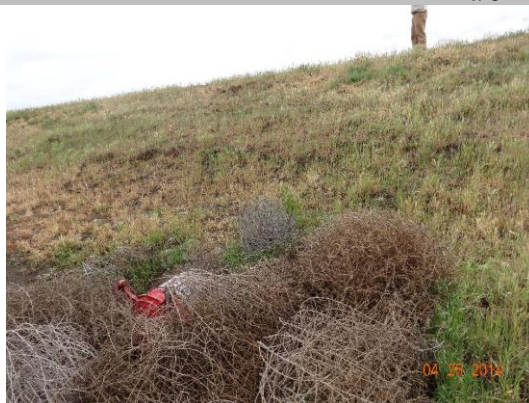
Photo 2 of 3 : UCIP\_SP\_2018\_39268\_65640.jpg

Item	DWR UCIP LMA Responsibility			37.199427 °		37.199427 °
				-120.760235 °		-120.760235 °
DWR ID						
Comment Code						
Inspector Comment						
FS_ID:39268						
DS_ID:19596						
EP_NO: N/A						
Repair Type: Non-Urgent						
Crossing Status: Found						
UCIP Comments: Dense vegetation limits the inspector's visibility to identify signs of pipe failure (leaks) along the waterward slope.						
Recommend removing vegetation along pipe alignment to conduct proper inspection of structure. Dense vegetation blocks both waterward and landward headwalls. Sediment buildup in pipe visible from landward side.						
FIELD_STRUCT_DESC: 24-inch corrugated metal gravity drainage pipe through the levee, 8 feet below the crown. Flap gate on the waterside (WS) end. Brass cap No. 40 bench mark (BM) on the headwall on the landside (LS). [Additional Reference(s): DWR Levee Log, 2002. USACE San Joaquin O&M Manual 601.1, 1967, (HLM 19.54)].

Flap gate visible on waterward side--potential erosion present on slope.

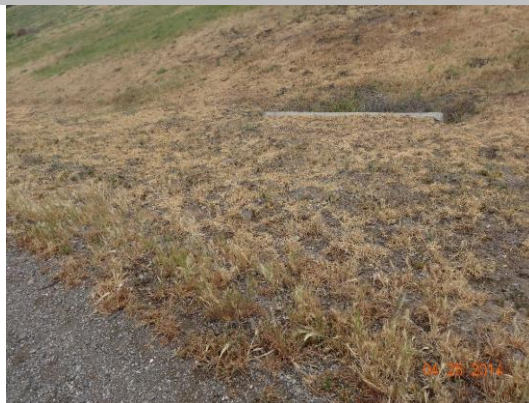
Photo 3 of 3 : UCIP\_SP\_2018\_39268\_65639.jpg

View of landward slope.

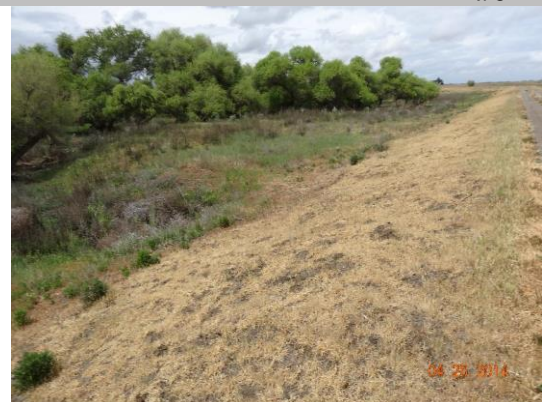
Photo 1 of 3 : UCIP\_SP\_2018\_39269\_65648.jpg

LM Start	20.18	Rating **	M	Issue No.	1261
LM End	20.18	Issue Type +	Ma	Location *	
Category	Supplemental			GPS Latitude/Longitude	
				Start	End
Item	DWR UCIP LMA Responsibility			37.194669 °	37.194669 °
				-120.759736 °	-120.759736 °
DWR ID					
Comment Code					
Inspector Comment					
FS_ID:39269 DS_ID:19598 EP_NO: N/A Repair Type: Non-Urgent Crossing Status: Found UCIP Comments: Recommend removing vegetation and sediment buildup from both waterward and landward concrete headwalls. FIELD_STRUCT_DESC: 24-inch corrugated metal gravity drainage pipe through the levee, 8.5 feet below the crown. Flap gate on the waterside (WS) end. Brass cap No. 40 bench mark (BM) on the headwall on the landside (LS). [Additional Reference(s): DWR Levee Log, 2002. USACE San Joaquin O&M Manual 601.1, 1967, (HLM 20.18)]. FS Date: 4/25/2014

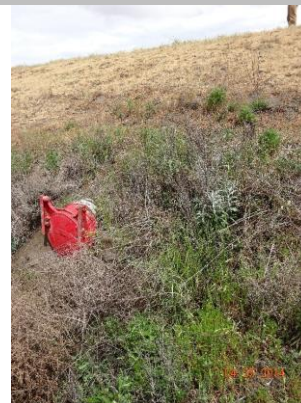
Photo 2 of 3 : UCIP\_SP\_2018\_39269\_65647.jpg

LM Start	20.18	Rating **	M	Issue No.	1261 (cont)	
LM End	20.18	Issue Type +	Ma	Location *		
Category	Supplemental			GPS Latitude/Longitude		
				Start	End	
Item	DWR UCIP LMA Responsibility			37.194669 °	37.194669 °	
				-120.759736 °	-120.759736 °	
DWR ID						
Comment Code						
Inspector Comment						
FS_ID:39269 DS_ID:19598 EP_NO: N/A Repair Type: Non-Urgent Crossing Status: Found UCIP Comments: Recommend removing vegetation and sediment buildup from both waterward and landward concrete headwalls. FIELD_STRUCT_DESC: 24-inch corrugated metal gravity drainage pipe through the levee, 8.5 feet below the crown. Flap gate on the waterside (WS) end. Brass cap No. 40 bench mark (BM) on the headwall on the landside (LS). [Additional Reference(s): DWR Levee Log, 2002. USACE San Joaquin O&M Manual 601.1, 1967, (HLM 20.18)]. FS Date: 4/25/2014

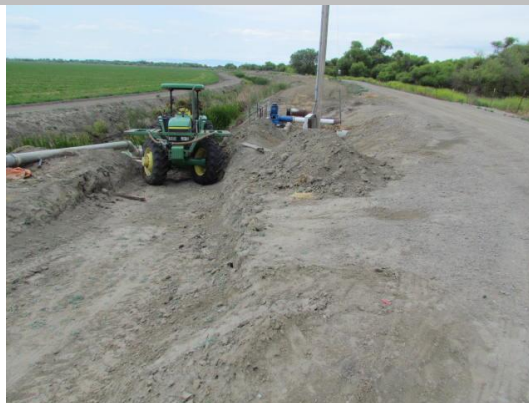
Photo 1 of 2 : SP\_2018\_NA0010\_118\_1184\_20180307\_00030.jpg

LM Start	<b>20.25</b>	Rating **	U	Issue No.	<b>1184 (cont)</b>
LM End	<b>20.25</b>	Issue Type +	En	Location *	LS

Looking north at ramp cut into landward slope.

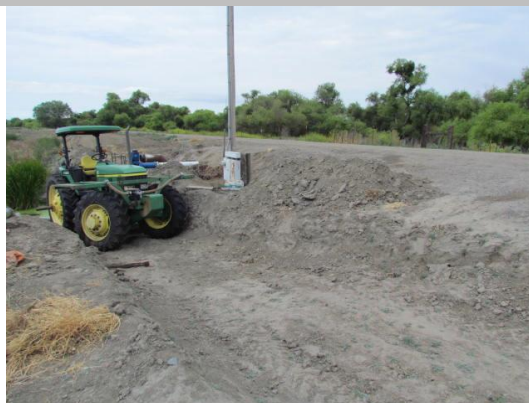
Photo 2 of 2 : SP\_2018\_NA0010\_118\_1184\_20180307\_00031.jpg

Looking east at ramp cut into landward slope.

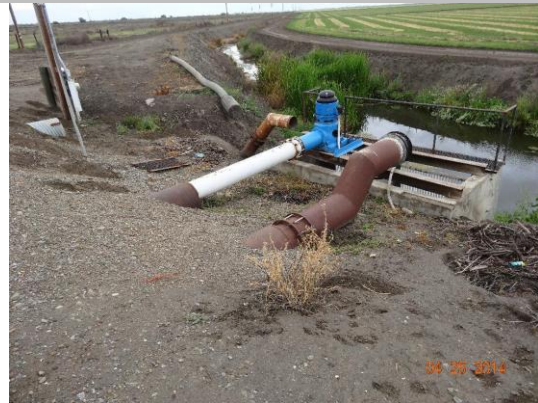
Photo 3 of 3 : UCIP\_SP\_2018\_39285\_71444.jpg

LM Start	20.26	Rating **	M	Issue No.	1262 (cont)	
LM End	20.26	Issue Type +	En	Location *		
Category	Supplemental			GPS Latitude/Longitude		
				Start		End
Item	DWR UCIP Field Study			37.193550 °		37.193550 °
				-120.760284 °		-120.760284 °
DWR ID						
Comment Code						
Inspector Comment						
FS_ID:39285 DS_ID:24873 EP_NO: N/A Repair Type: Non-Urgent Crossing Status: Found UCIP Comments: Dense vegetation limits the inspector's visibility to identify signs of pipe failure (leaks) along the waterward slope. Recommend removing vegetation along pipe alignment to conduct proper inspection of structure. FIELD_STRUCT_DESC: 12-inch steel drainage discharge pipe sleeved through a 24-inch steel pipe through levee, at an unknown depth. FS Date: 4/25/2014

View of landward side.

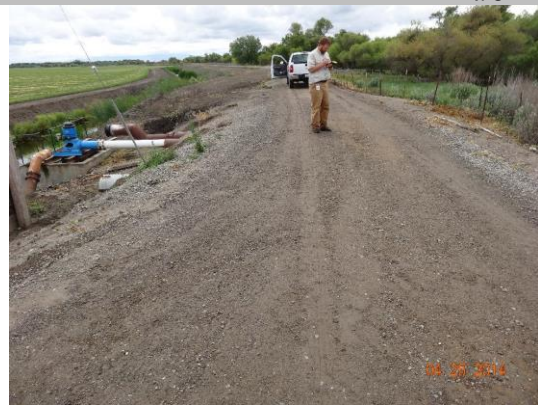
Photo 1 of 3 : UCIP\_SP\_2018\_49965\_66303.jpg

Comment Code						
Inspector Comment						
FS_ID:49965 DS_ID:19599 EP_NO: N/A Repair Type: Non-Urgent Crossing Status: Found UCIP Comments: 7/19/2016 same as previous inspection. crossing was downgraded from Urgent to Non-Urgent due to metal rod not interfering with flap gate. (DWR UCIP - omagana)4/25/2014 Unauthorized crossing through pipe. Line was pushed through existing crossing. Need to contact owner. Also sediment buildup in pipe visible from landward side--recommend clearing. (DWR UCIP - omagana) FIELD_STRUCT_DESC: 24-inch corrugated metal gravity drainage pipe through the levee, 5 feet below the crown. Flap gate on the waterside (WS) end. No permit for this crossing. [Additional Reference(s): DWR Levee Log, 2002]. FS Date: 7/19/2016

Overview of levee crown at crossing.

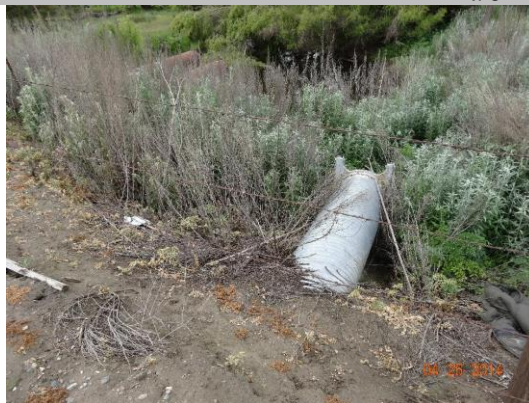
Photo 2 of 3 : UCIP\_SP\_2018\_49965\_66304.jpg

Item	DWR UCIP Field Study			37.193542 °	37.193542 °	
				-120.760300 °	-120.760300 °	
DWR ID						
Comment Code						
Inspector Comment						
FS_ID:49965 DS_ID:19599 EP_NO: N/A Repair Type: Non-Urgent Crossing Status: Found UCIP Comments: 7/19/2016 same as previous inspection. crossing was downgraded from Urgent to Non-Urgent due to metal rod not interfering with flap gate. (DWR UCIP - omagana)4/25/2014 Unauthorized crossing through pipe. Line was pushed through existing crossing. Need to contact owner. Also sediment buildup in pipe visible from landward side--recommend clearing. (DWR UCIP - omagana) FIELD_STRUCT_DESC: 24-inch corrugated metal gravity drainage pipe through the levee, 5 feet below the crown. Flap gate on the waterside (WS) end. No permit for this crossing. [Additional Reference(s): DWR Levee Log, 2002]. FS Date: 7/19/2016

View of WS.

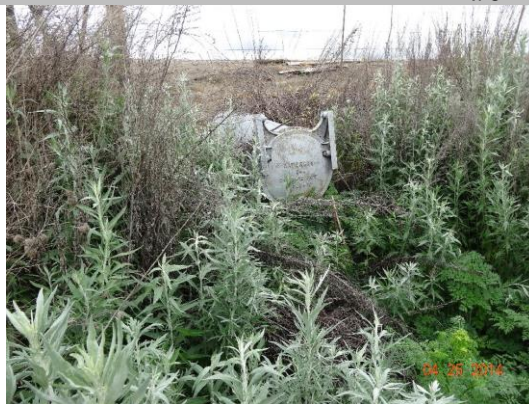
Photo 3 of 3 : UCIP\_SP\_2018\_49965\_66302.jpg

View of WS.

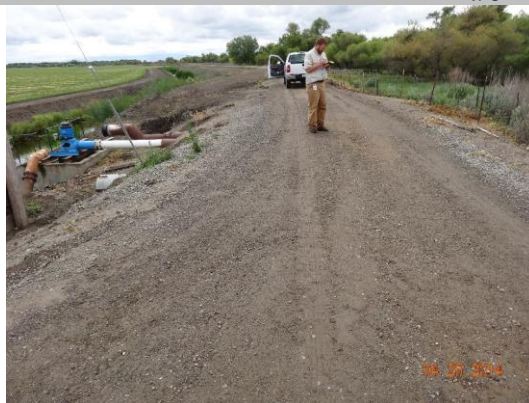
Photo 1 of 3 : UCIP\_SP\_2018\_39878\_66308.jpg

Comment Code						
Inspector Comment						
FS_ID:39878						
DS_ID:19600						
EP_NO: N/A						
Repair Type: Non-Urgent						
Crossing Status: Found						
UCIP Comments: Crossing partially submersed--no signs of failure of pipe present along pipe alignment. Recommend contacting owner to determine status of crossing and condition.						
FIELD_STRUCT_DESC: 36-inch corrugated metal gravity drainage pipe through the levee, 10.5 feet below the crown. Flap gate on the waterside (WS) end. Brass cap No. 40 bench mark (BM) on the headwall on the landside (LS). [Additional Reference(s): DWR Levee Log, 2002. USACE San Joaquin O&M Manual 601.1, 1967, (HLM 20.27)].						
FS Date: 4/25/2014

Overview of levee crown at crossing--multiple crossings at this location.

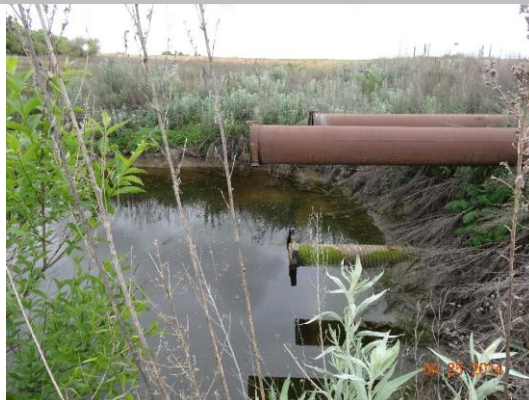
Photo 2 of 3 : UCIP\_SP\_2018\_39878\_66309.jpg

Multiple crossings visible on waterward side--36 inch CMP is submersed in water.

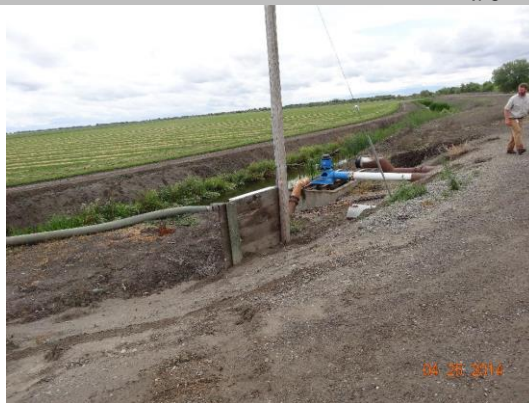
Photo 3 of 3 : UCIP\_SP\_2018\_39878\_66307.jpg

Item	DWR UCIP LMA Responsibility			37.193542 °	37.193542 °	
				-120.760300 °	-120.760300 °	
DWR ID						
Comment Code						
Inspector Comment						
FS_ID:39878 DS_ID:19600 EP_NO: N/A Repair Type: Non-Urgent Crossing Status: Found UCIP Comments: Crossing partially submersed--no signs of failure of pipe present along pipe alignment. Recommend contacting owner to determine status of crossing and condition. FIELD_STRUCT_DESC: 36-inch corrugated metal gravity drainage pipe through the levee, 10.5 feet below the crown. Flap gate on the waterside (WS) end. Brass cap No. 40 bench mark (BM) on the headwall on the landside (LS). [Additional Reference(s): DWR Levee Log, 2002. USACE San Joaquin O&M Manual 601.1, 1967, (HLM 20.27)]. FS Date: 4/25/2014

View of landward side.

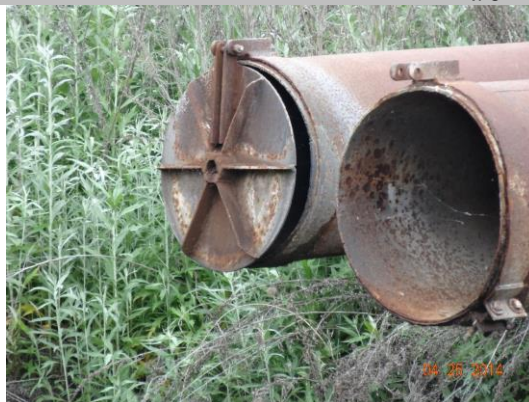
Photo 1 of 3 : UCIP\_SP\_2018\_39286\_71442.jpg

LM Start	20.27	Rating **	M	Issue No.	1265	
LM End	20.27	Issue Type +	En	Location *		
Category	Supplemental			GPS Latitude/Longitude		
				Start	End	
Item	DWR UCIP Field Study			37.193542 °	37.193542 °	
				-120.760300 °	-120.760300 °	
DWR ID						
Comment Code						
Inspector Comment						
FS_ID:39286						
DS_ID:24874						
EP_NO: N/A						
Repair Type: Non-Urgent						
Crossing Status: Found						
UCIP Comments: Dense vegetation limits the inspector's visibility to identify signs of pipe failure (leaks) along the waterward slope.						
Recommend removing vegetation along pipe alignment to conduct proper inspection of structure.						
FIELD_STRUCT_DESC: 18-inch steel drainage discharge pipe sleeved through a 24-inch steel pipe through levee, at an unknown depth.						
FS Date: 4/25/2014

Outlets visible on waterward side.

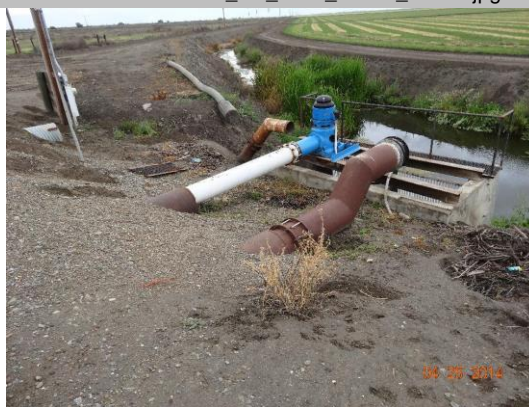
Photo 3 of 3 : UCIP\_SP\_2018\_39286\_71440.jpg

LM Start	20.27	Rating **	M	Issue No.	1265 (cont)	
LM End	20.27	Issue Type +	En	Location *		
Category	Supplemental			GPS Latitude/Longitude		
				Start	End	
Item	DWR UCIP Field Study			37.193542 °	37.193542 °	
				-120.760300 °	-120.760300 °	
DWR ID						
Comment Code						
Inspector Comment						
FS_ID:39286						
DS_ID:24874						
EP_NO: N/A						
Repair Type: Non-Urgent						
Crossing Status: Found						
UCIP Comments: Dense vegetation limits the inspector's visibility to identify signs of pipe failure (leaks) along the waterward slope.						
Recommend removing vegetation along pipe alignment to conduct proper inspection of structure.						
FIELD_STRUCT_DESC: 18-inch steel drainage discharge pipe sleeved through a 24-inch steel pipe through levee, at an unknown depth.						
FS Date: 4/25/2014

View of landward side.

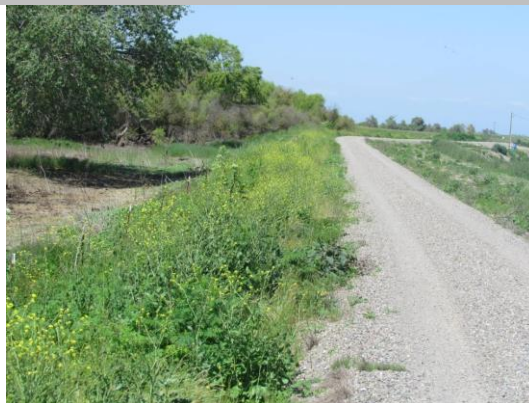
Photo 1 of 1 : SP\_2018\_NA0010\_118\_8\_20180307\_00005.jpg

LM Start	21.24	Rating **	U	Issue No.	8
LM End	22.46	Issue Type +	Ma	Location *	WS
Category	Earthen Levee			GPS Latitude/Longitude	
				Start	End
Item	Vegetation			37.181042 °	37.167498 °
				-120.762886 °	-120.750862 °
DWR ID	DWR_NA0010_01_f_2015_8				
Comment Code					
V2 : Remove the wild growth other than native grasses from the levee slopes.					
Inspector Comment					
Dense vegetation on waterside slope.

Looking downstream at dense veg on waterward slope.

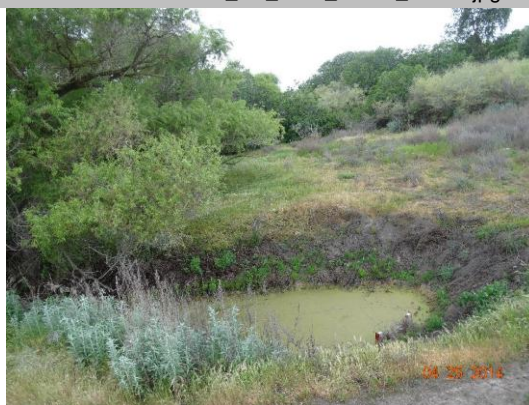
Photo 1 of 3 : UCIP\_SP\_2018\_39271\_66312.jpg

Comment Code					
Inspector Comment					
FS_ID:39271 DS_ID:19603 EP_NO: N/A Repair Type: Non-Urgent Crossing Status: Found UCIP Comments: Crossing is non-functional--crossing buried on landward side. Need to contact owner to determine status of crossing. If crossing is no longer used need to coordinate with CVFPB for proper abandonment. FIELD_STRUCT_DESC: 36-inch corrugated metal gravity drainage pipe through the levee, 11.5 feet below the crown. Flap gate on the waterside (WS) end. Brass cap No. 40 bench mark (BM) on the headwall on the landside (LS). [Additional Reference(s): DWR Levee Log, 2002. USACE San Joaquin O&M Manual 601.1, 1967, (HLM 21.40)]. FS Date: 4/25/2014

View of waterward side.

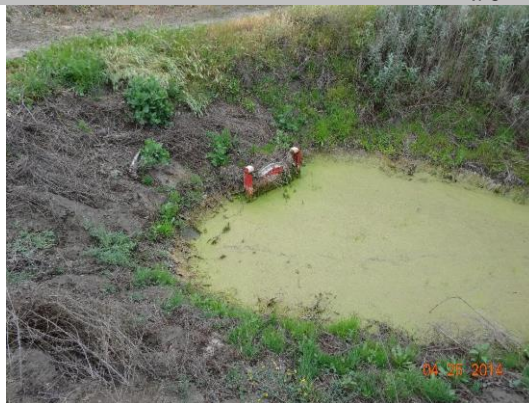
Photo 2 of 3 : UCIP\_SP\_2018\_39271\_66313.jpg

Comment Code					
Inspector Comment					
FS_ID:39271 DS_ID:19603 EP_NO: N/A Repair Type: Non-Urgent Crossing Status: Found UCIP Comments: Crossing is non-functional--crossing buried on landward side. Need to contact owner to determine status of crossing. If crossing is no longer used need to coordinate with CVFPB for proper abandonment. FIELD_STRUCT_DESC: 36-inch corrugated metal gravity drainage pipe through the levee, 11.5 feet below the crown. Flap gate on the waterside (WS) end. Brass cap No. 40 bench mark (BM) on the headwall on the landside (LS). [Additional Reference(s): DWR Levee Log, 2002. USACE San Joaquin O&M Manual 601.1, 1967, (HLM 21.40)]. FS Date: 4/25/2014

Flap gate half way submersed located on waterward side.

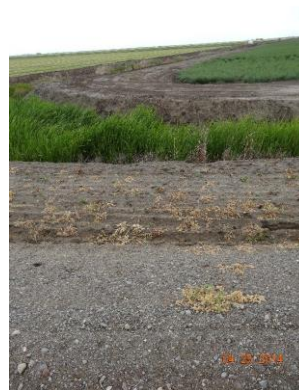
Photo 3 of 3 : UCIP\_SP\_2018\_39271\_66311.jpg

View of landward side.

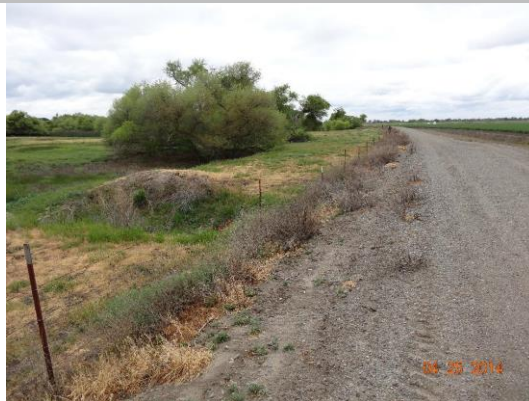
Photo 1 of 3 : UCIP\_SP\_2018\_39272\_65697.jpg

Comment Code					
Inspector Comment					
FS_ID:39272 DS_ID:19604 EP_NO: N/A Repair Type: Non-Urgent Crossing Status: Found UCIP Comments: Non-functional crossing-landward side is buried. Need to contact owner to determine status of crossing. If crossing is no longer used need to coordinate with CVFPB for proper abandonment. FIELD_STRUCT_DESC: 24-inch corrugated metal gravity drainage pipe through the levee, 9 feet below the crown. Flap gate on the waterside (WS) end. Brass cap No. 40 bench mark (BM) on the headwall on the landside (LS). [Additional Reference(s): DWR Levee Log, 2002. USACE San Joaquin O&M Manual 601.1, 1967, (HLM 21.76)]. FS Date: 4/25/2014

View of waterward side.

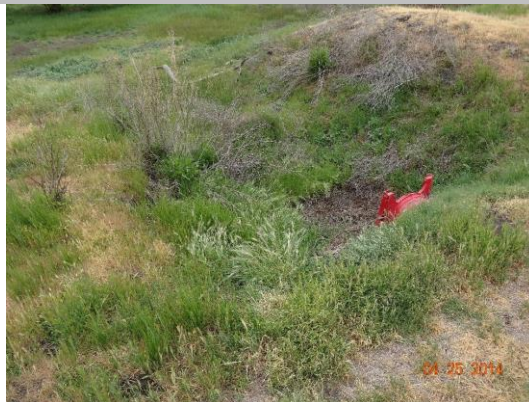
Photo 2 of 3 : UCIP\_SP\_2018\_39272\_65695.jpg

Flap gate visible on waterward side.

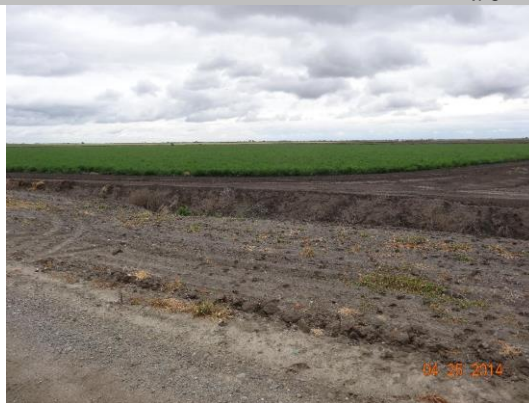
Photo 3 of 3 : UCIP\_SP\_2018\_39272\_65696.jpg

Item	DWR UCIP LMA Responsibility			37.176106 °	37.176106 °	
				-120.756768 °	-120.756768 °	
DWR ID						
Comment Code						
Inspector Comment						
FS_ID:39272						
DS_ID:19604						
EP_NO: N/A						
Repair Type: Non-Urgent						
Crossing Status: Found						
UCIP Comments: Non-functional crossing-landward side is buried.						
Need to contact owner to determine status of crossing. If crossing is no						
longer used need to coordinate with CVFPB for proper abandonment.						
FIELD_STRUCT_DESC: 24-inch corrugated metal gravity drainage pipe						
through the levee, 9 feet below the crown. Flap gate on the waterside						
(WS) end. Brass cap No. 40 bench mark (BM) on the headwall on the						
landside (LS). [Additional Reference(s): DWR Levee Log, 2002. USACE						
San Joaquin O&M Manual 601.1, 1967, (HLM 21.76)].						
FS Date: 4/25/2014

View of landward side.

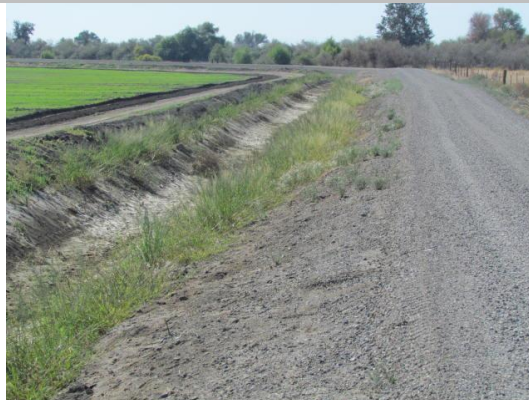
Photo 1 of 3 : SP\_2018\_NA0010\_118\_22\_20180307\_00013.jpg

LM Start	22.06	Rating **	U	Issue No.	22
LM End	22.52	Issue Type +	En	Location *	LS
Category	Earthen Levee			GPS Latitude/Longitude	
				Start	End
Item	Encroachments			37.172074 °	37.166906 °
				-120.754628 °	-120.749962 °
DWR ID	DWR_NA0010_01_s _ 2012_22				
Comment Code					
DT : Ditch					
Inspector Comment					
Ditch has encroached into landside toe and slope.

Looking downstream at irrigation ditch at LM 22.06

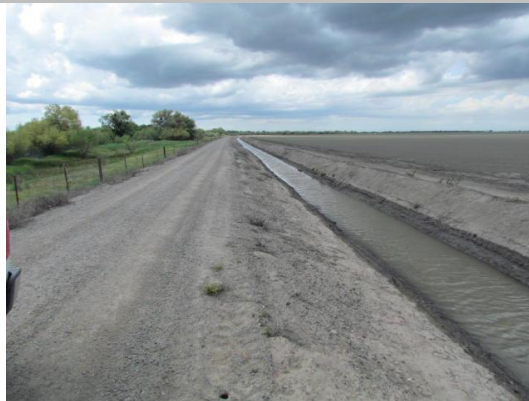
Photo 2 of 3 : SP\_2018\_NA0010\_118\_22\_20180307\_00014.jpg

LM Start	22.06	Rating **	U	Issue No.	22 (cont)	
LM End	22.52	Issue Type +	En	Location *	LS	
Category	Earthen Levee			GPS Latitude/Longitude		
				Start		End
Item	Encroachments			37.172074 °		37.166906 °
				-120.754628 °		-120.749962 °
DWR ID	DWR_NA0010_01_s_2012_22					
Comment Code						
DT : Ditch						
Inspector Comment						
Ditch has encroached into landside toe and slope.

Looking downstream at irrigation ditch at landside toe.

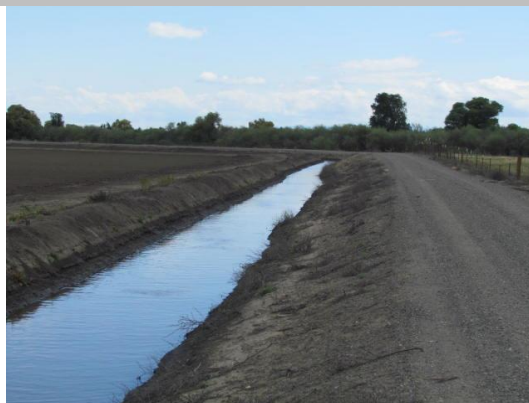
Photo 3 of 3 : SP\_2018\_NA0010\_118\_22\_20180307\_00015.jpg

Looking upstream at irrigation at landside toe.

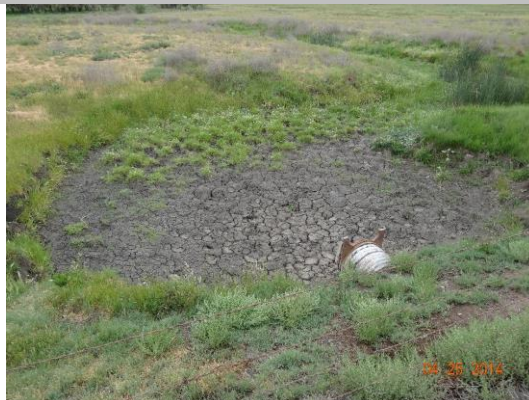
Photo 2 of 3 : UCIP\_SP\_2018\_39273\_65707.jpg

Flap gate visible on waterward side.

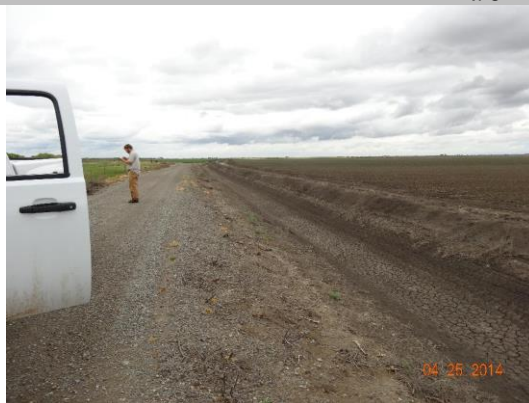
Photo 3 of 3 : UCIP\_SP\_2018\_39273\_65708.jpg

Item	DWR UCIP LMA Responsibility			37.171181 °	37.171181 °	
				-120.754526 °	-120.754526 °	
DWR ID						
Comment Code						
Inspector Comment						
FS_ID:39273						
DS_ID:19605						
EP_NO: N/A						
Repair Type: Non-Urgent						
Crossing Status: Found						
UCIP Comments: Non-functional crossing--landward side is buried.						
Need to contact owner to determine status. If crossing is no longer used						
need to coordinate with CVFPB for proper abandonment.						
FIELD_STRUCT_DESC: 24-inch corrugated metal gravity drainage pipe						
through the levee, 9 feet below the crown. Flap gate on the waterside						
(WS) end. Wooden headboards on the landside (LS) end. Brass cap						
No. 31 bench mark (BM) on the headwall on the LS. [Additional						
Reference(s): DWR Levee Log, 2002. USACE San Joaquin O&M						
Manual 601.1, 1967, (HLM 22.13)].						
FS Date: 4/25/2014

View of landward side.

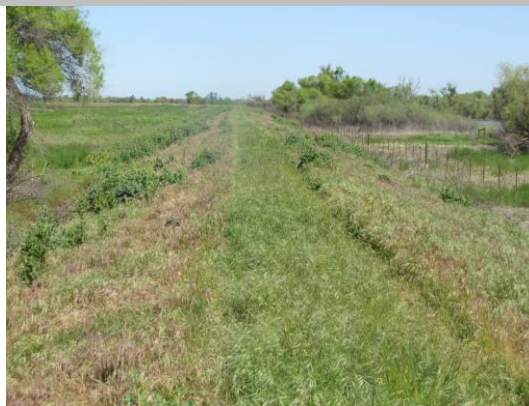
Photo 1 of 1 : SP\_2018\_NA0010\_119\_23\_20180307\_00011.jpg

LM Start	0.00	Rating **	U	Issue No.	23
LM End	1.02	Issue Type +	Ma	Location *	CR
Category	Earthen Levee			GPS Latitude/Longitude	
				Start	End
Item	Vegetation			37.296270 °	37.284950 °
				-120.880690 °	-120.871212 °
DWR ID	DWR_NA0010_02A_s_2017_23				
Comment Code					
V9 : Keep the crown roadway free of vegetation.					
Inspector Comment					
Control veg on levee crown and add additional base on levee crown.

Looking downstream at overgrown levee crown.

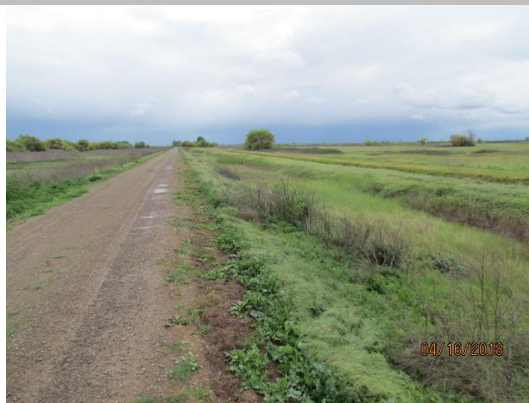
Photo 1 of 1 : SP\_2018\_NA0010\_119\_29\_20180419\_00072.jpg

LM Start	0.00	Rating **	M	Issue No.	29
LM End	7.87	Issue Type +	Ma	Location *	LS
Category	Earthen Levee			GPS Latitude/Longitude	
				Start	End
Item	Vegetation			37.296280 °	37.231283 °
				-120.880669 °	-120.811884 °
DWR ID	DWR_NA0010_02A_s_2018_29				
Comment Code					
V1 : Control annual grass and weeds on the levee slopes and easements.					
Inspector Comment

Looking south at typical view of landward slope. (Spring 2018)

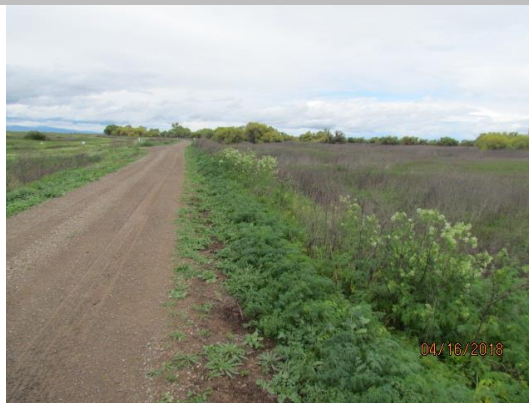
Photo 1 of 1 : SP\_2018\_NA0010\_119\_30\_20180419\_00073.jpg

LM Start	0.00	Rating **	M	Issue No.	30
LM End	7.87	Issue Type +	Ma	Location *	WS
Category	Earthen Levee			GPS Latitude/Longitude	
				Start	End
Item	Vegetation			37.296279 °	37.231282 °
				-120.880669 °	-120.811884 °
DWR ID	DWR_NA0010_02A_s_2018_30				
Comment Code					
V1 : Control annual grass and weeds on the levee slopes and easements.					
Inspector Comment

Looking north at typical view of waterward slope. (Spring 2018)

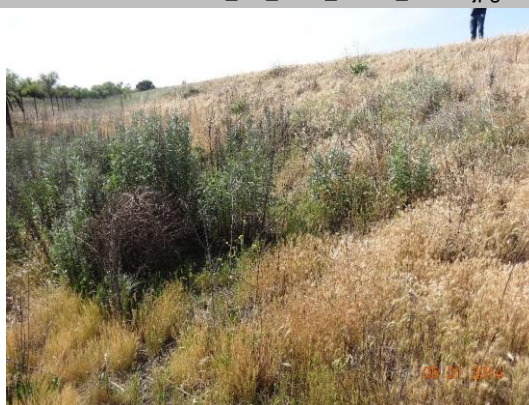
Photo 1 of 3 : UCIP\_SP\_2018\_36503\_66102.jpg

Comment Code					
Inspector Comment					
FS_ID:36503 DS_ID:19652 EP_NO: N/A Repair Type: Non-Urgent Crossing Status: Found UCIP Comments: Dense vegetation limits the inspector's visibility to identify signs of pipe failure (leaks) along the slope. Recommend removing vegetation along pipe alignment to conduct proper inspection of structure. FIELD_STRUCT_DESC: 24-inch corrugated metal gravity drainage pipe through the levee, 11 feet below the crown. Flap gate on the waterside (WS) end. Brass cap No. 139 bench mark (BM) on the headwall on the landside (LS). [Additional Reference(s): DWR Levee Log, 2002. USACE San Joaquin O&M Manual 601.1, 1967, (HLM 0.24)]. FS Date: 5/1/2014

View of waterward side.

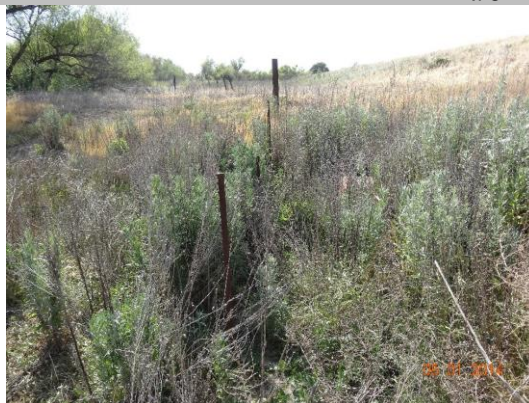
Photo 2 of 3 : UCIP\_SP\_2018\_36503\_66101.jpg

Comment Code						
Inspector Comment						
FS_ID:36503 DS_ID:19652 EP_NO: N/A Repair Type: Non-Urgent Crossing Status: Found UCIP Comments: Dense vegetation limits the inspector's visibility to identify signs of pipe failure (leaks) along the slope. Recommend removing vegetation along pipe alignment to conduct proper inspection of structure. FIELD_STRUCT_DESC: 24-inch corrugated metal gravity drainage pipe through the levee, 11 feet below the crown. Flap gate on the waterside (WS) end. Brass cap No. 139 bench mark (BM) on the headwall on the landside (LS). [Additional Reference(s): DWR Levee Log, 2002. USACE San Joaquin O&M Manual 601.1, 1967, (HLM 0.24)]. FS Date: 5/1/2014

Fence along waterward side. No headwall was found on waterward side.

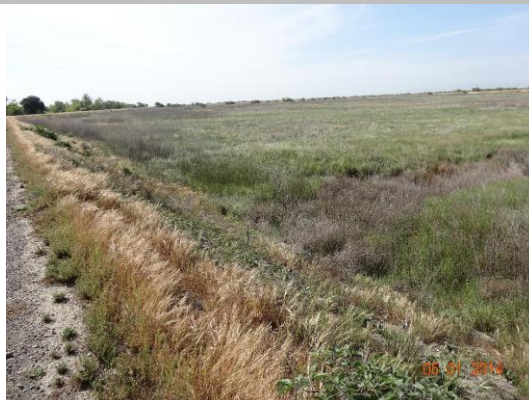
Photo 3 of 3 : UCIP\_SP\_2018\_36503\_66100.jpg

View of landward side.

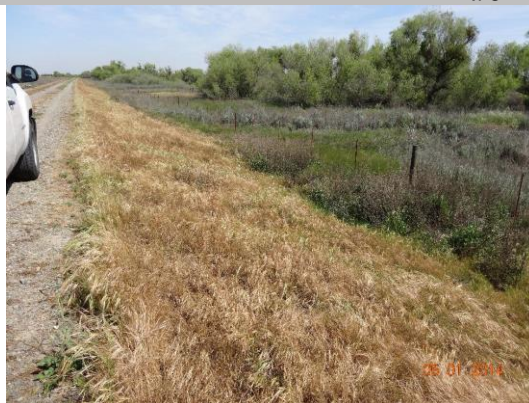
Photo 1 of 3 : UCIP\_SP\_2018\_36504\_66106.jpg

Comment Code					
Inspector Comment					
FS_ID:36504 DS_ID:19653 EP_NO: N/A Repair Type: Non-Urgent Crossing Status: Found UCIP Comments: Dense vegetation limits the inspector's visibility to identify signs of pipe failure (leaks) along the slope. Recommend removing vegetation along pipe alignment to conduct proper inspection of structure. FIELD_STRUCT_DESC: 24-inch corrugated metal gravity drainage pipe through the levee, 14.8 feet below the crown. Flap gate on the waterside (WS) end. Brass cap No. 138 bench mark (BM) on the headwall on the landside (LS). [Additional Reference(s): DWR Levee Log, 2002. USACE San Joaquin O&M Manual 601.1, 1967, (HLM 0.67)]. FS Date: 5/1/2014

View of waterward side.

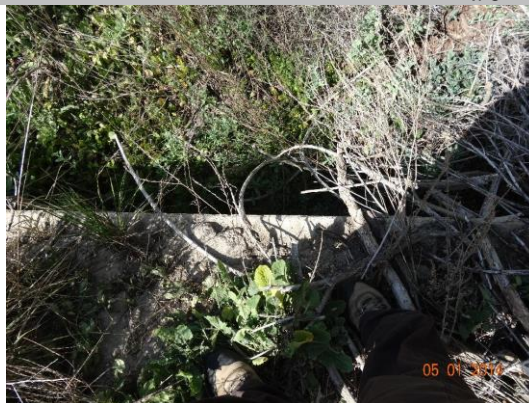
Photo 3 of 3 : UCIP\_SP\_2018\_36504\_66104.jpg

Comment Code						
Inspector Comment						
FS_ID:36504 DS_ID:19653 EP_NO: N/A Repair Type: Non-Urgent Crossing Status: Found UCIP Comments: Dense vegetation limits the inspector's visibility to identify signs of pipe failure (leaks) along the slope. Recommend removing vegetation along pipe alignment to conduct proper inspection of structure. FIELD_STRUCT_DESC: 24-inch corrugated metal gravity drainage pipe through the levee, 14.8 feet below the crown. Flap gate on the waterside (WS) end. Brass cap No. 138 bench mark (BM) on the headwall on the landside (LS). [Additional Reference(s): DWR Levee Log, 2002. USACE San Joaquin O&M Manual 601.1, 1967, (HLM 0.67)]. FS Date: 5/1/2014

Concrete headwall found on landward side.

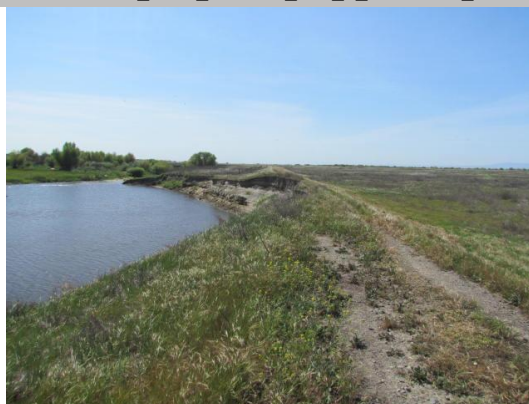
Photo 1 of 4 : SP\_2018\_NA0010\_119\_5\_20180307\_00005.jpg

LM Start	0.72	Rating **	U	Issue No.	5
LM End	0.78	Issue Type +	Ma	Location *	WS
Category	Earthen Levee			GPS Latitude/Longitude	
				Start	End
Item	Erosion / Bank Caving			37.287269 °	37.286543 °
				-120.874491 °	-120.873935 °
DWR ID	DWR_NA0010_02A_s_2012_5				
Comment Code					
E2 : Schedule repair of erosion site prior to the next inspection.					
Inspector Comment					
A field investigation report in on file. For more information and pictures see field investigation report #4301.

Looking south at large erosion on waterside slope. (Spring 2012)

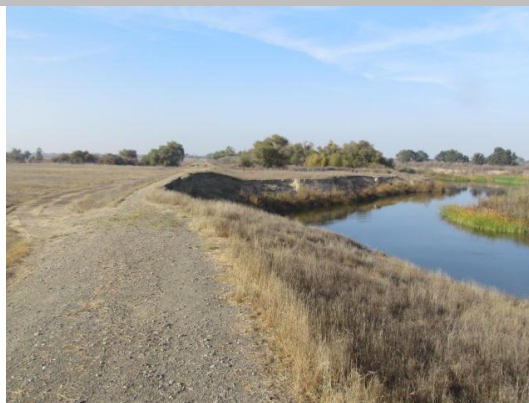
Photo 3 of 4 : SP\_2018\_NA0010\_119\_5\_20180307\_00007.jpg

Looking north at erosion on waterward slope. (Fall 2014)

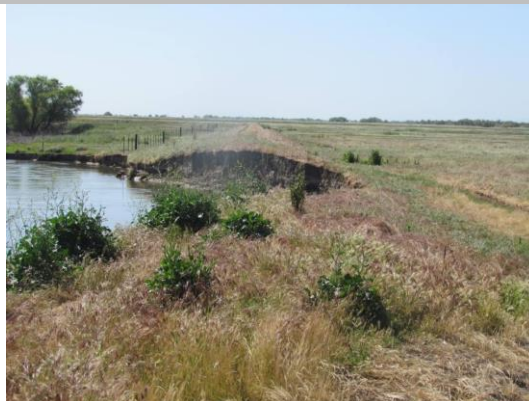
Photo 4 of 4 : SP\_2018\_NA0010\_119\_5\_20180307\_00008.jpg

Looking upstream at erosion fall 2017.

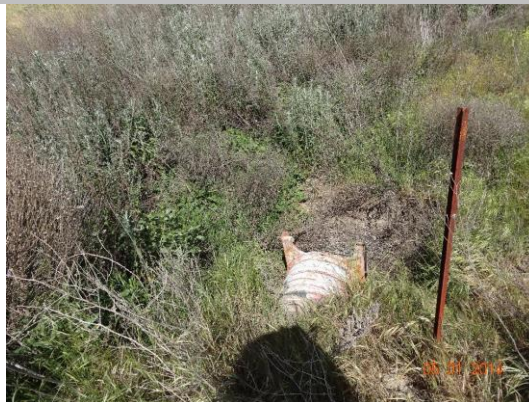
Photo 2 of 3 : UCIP\_SP\_2018\_39363\_66112.jpg

Pipe visible on waterward side.

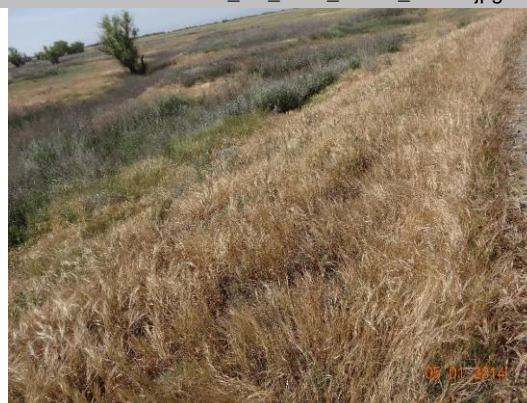
Photo 1 of 3 : UCIP\_SP\_2018\_36507\_66120.jpg

Comment Code						
Inspector Comment						
FS_ID:36507 DS_ID:19656 EP_NO: N/A Repair Type: Non-Urgent Crossing Status: Found UCIP Comments: Dense vegetation limits the inspector's visibility to identify signs of pipe failure (leaks) along the slope. Recommend removing vegetation along pipe alignment to conduct proper inspection of structure. FIELD_STRUCT_DESC: 36-inch corrugated metal gravity drainage pipe through the levee, 14.6 feet below the crown. Flap gate on the waterside (WS) end. Brass cap No. 135 bench mark (BM) on the headwall on the landside (LS). [Additional Reference(s): DWR Levee Log, 2002. USACE San Joaquin O&M Manual 601.1, 1967, (HLM 1.34)]. FS Date: 5/1/2014

View of landward side.

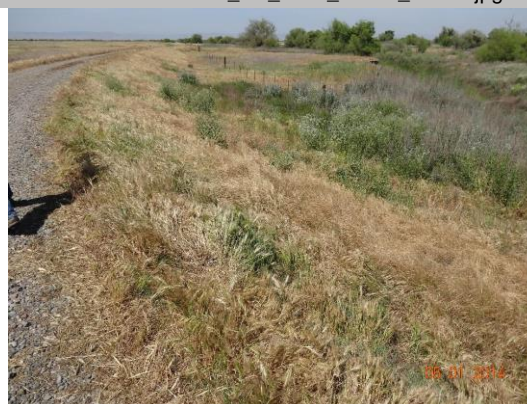
Photo 2 of 3 : UCIP\_SP\_2018\_36507\_66119.jpg

View of waterward side.

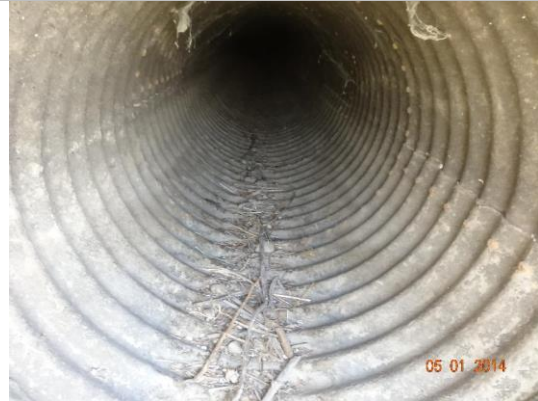
Photo 3 of 3 : UCIP\_SP\_2018\_36509\_66127.jpg

Comment Code						
Inspector Comment						
FS_ID:36509 DS_ID:19658 EP_NO: N/A Repair Type: Non-Urgent Crossing Status: Found UCIP Comments: Dense vegetation limits the inspector's visibility to identify signs of pipe failure (leaks) along the slope. Recommend removing vegetation along pipe alignment to conduct proper inspection of structure. FIELD_STRUCT_DESC: 24-inch corrugated metal gravity drainage pipe through the levee, 10.7 feet below the crown. Flap gate on the waterside (WS) end. Brass cap No. 135 bench mark (BM) on the headwall on the landside (LS). [Additional Reference(s): DWR Levee Log, 2002. USACE San Joaquin O&M Manual 601.1, 1967, (HLM 1.86)]. FS Date: 5/1/2014

Inside view of pipe from landward side.

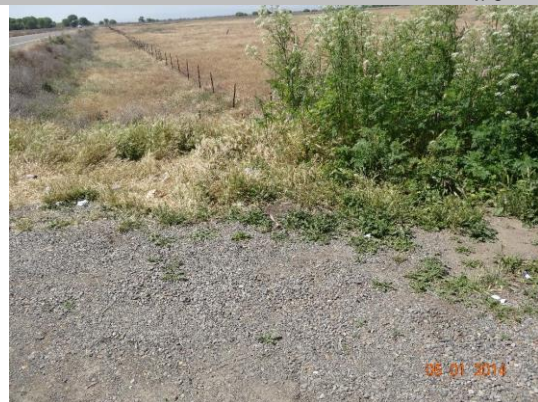
Photo 1 of 3 : UCIP\_SP\_2018\_36510\_66133.jpg

Comment Code						
Inspector Comment						
FS_ID:36510						
DS_ID:19659						
EP_NO: N/A						
Repair Type: Non-Urgent						
Crossing Status: Found						
UCIP Comments: Dense vegetation limits the inspector's visibility to identify signs of pipe failure (leaks) along the slope. Recommend removing vegetation along pipe alignment to conduct proper inspection of structure.						
FIELD_STRUCT_DESC: 24-inch corrugated metal gravity drainage pipe through the levee, 7 feet below the crown. Flap gate on the waterside (WS) end. Brass cap No. 135 bench mark (BM) on the headwall on the landside (LS). [Additional Reference(s): DWR Levee Log, 2002. USACE San Joaquin O&M Manual 601.1, 1967, (HLM 2.30)].						
FS Date: 5/1/2014

View of landward side.

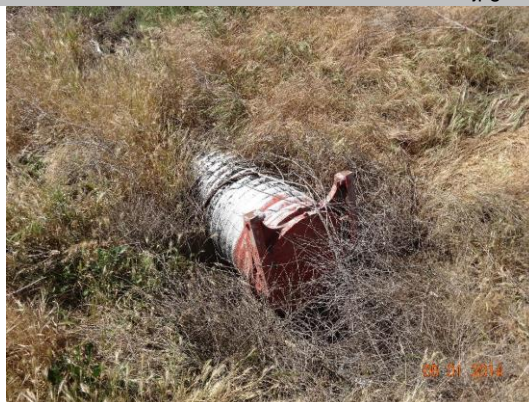
Photo 2 of 3 : UCIP\_SP\_2018\_36511\_66136.jpg

Flap gate visible on waterward side.

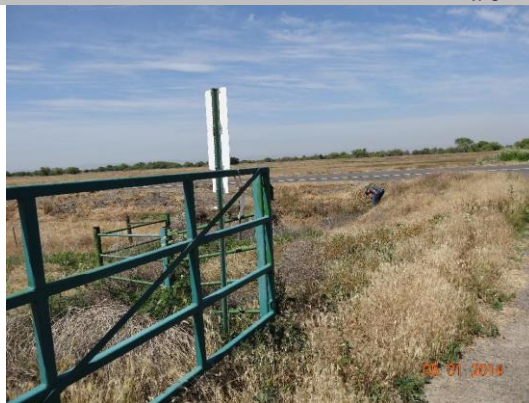
Photo 3 of 3 : UCIP\_SP\_2018\_36511\_66138.jpg

Comment Code						
Inspector Comment						
FS_ID:36511 DS_ID:19660 EP_NO: N/A Repair Type: Non-Urgent Crossing Status: Found UCIP Comments: Dense vegetation limits the inspector's visibility to identify signs of pipe failure (leaks) along the slope. Recommend removing vegetation along pipe alignment to conduct proper inspection of structure. FIELD_STRUCT_DESC: 24-inch corrugated metal gravity drainage pipe through the levee, 7 feet below the crown. Flap gate on the waterside (WS) end. Brass cap No. 135 bench mark (BM) on the headwall on the landside (LS). [Additional Reference(s): DWR Levee Log, 2002. USACE San Joaquin O&M Manual 601.1, 1967, (HLM 2.32)]. FS Date: 5/1/2014

Overview of landward slope.

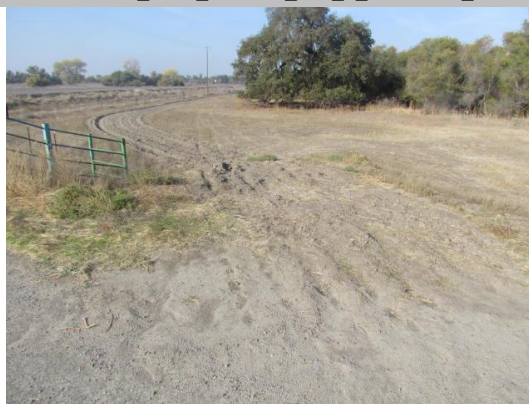
Photo 1 of 4 : SP\_2018\_NA0010\_119\_2\_20180307\_00001.jpg

LM Start	2.32	Rating **	M	Issue No.	2
LM End	2.32	Issue Type +	En	Location *	LS
Category	Earthen Levee			GPS Latitude/Longitude	
				Start	End
Item	Encroachments			37.291433 °	37.291433 °
				-120.850917 °	-120.850917 °
DWR ID	DWR_NA0010_02A_s_2012_2				
Comment Code					
RA : Ramp					
Inspector Comment					
Unauthorized ramp on landside and waterside slope.

Looking northeast at unauthorized ramp on landward slope.

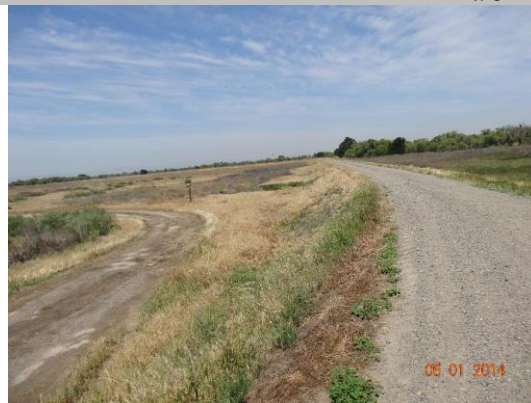
Photo 1 of 3 : UCIP\_SP\_2018\_36512\_66142.jpg

Comment Code					
Inspector Comment					
FS_ID:36512 DS_ID:19661 EP_NO: N/A Repair Type: Non-Urgent Crossing Status: Found UCIP Comments: Dense vegetation limits the inspector's visibility to identify signs of pipe failure (leaks) along the slope. Recommend removing vegetation along pipe alignment to conduct proper inspection of structure. FIELD_STRUCT_DESC: 24-inch corrugated metal gravity drainage pipe through the levee, 10 feet below the crown. Flap gate on the waterside (WS) end. Brass cap No. 130 bench mark (BM) on the headwall on the landside (LS). [Additional Reference(s): DWR Levee Log, 2002. USACE San Joaquin O&M Manual 601.1, 1967, (HLM 2.59)]. FS Date: 5/1/2014

View of landward side.

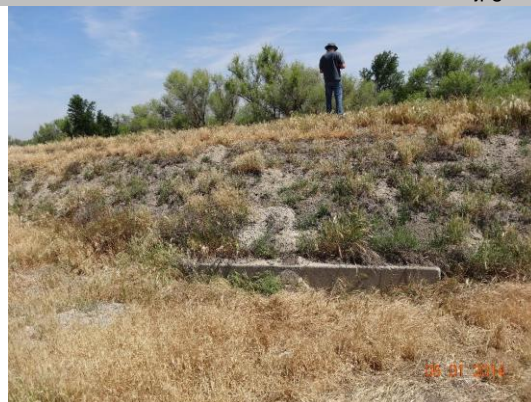
Photo 2 of 3 : UCIP\_SP\_2018\_36512\_66141.jpg

Concrete headwall visible on landward side.

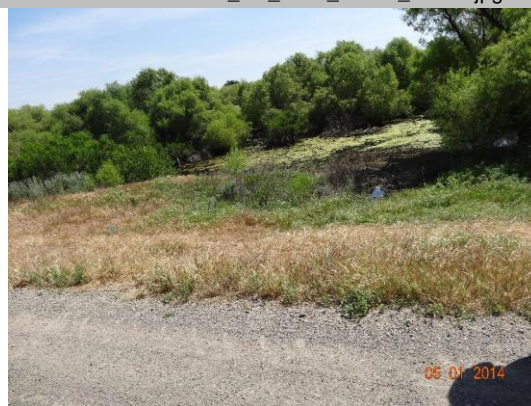
Photo 1 of 3 : UCIP\_SP\_2018\_36514\_66151.jpg

Comment Code					
Inspector Comment					
FS_ID:36514 DS_ID:19665 EP_NO: N/A Repair Type: Non-Urgent Crossing Status: Found UCIP Comments: Dense vegetation limits the inspector's visibility to identify signs of pipe failure (leaks) along the slope. Recommend removing vegetation along pipe alignment to conduct proper inspection of structure. FIELD_STRUCT_DESC: 24-inch corrugated metal gravity drainage pipe through the levee, 12.4 feet below the crown. Flap gate on the waterside (WS) end. Brass cap No. 130 bench mark (BM) on the headwall on the landside (LS). [Additional Reference(s): DWR Levee Log, 2002. USACE San Joaquin O&M Manual 601.1, 1967, (HLM 3.29)]. FS Date: 5/1/2014

View of waterward side.

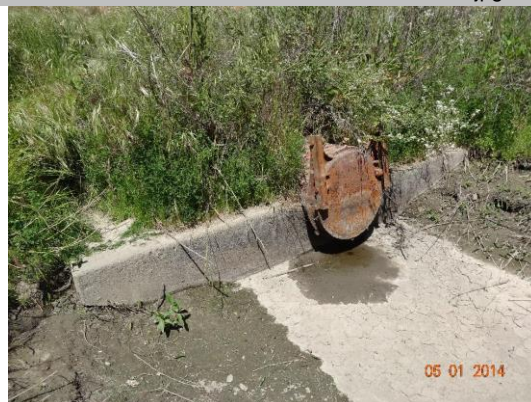
Photo 2 of 3 : UCIP\_SP\_2018\_36514\_66153.jpg

Flap gate visible on waterward side.

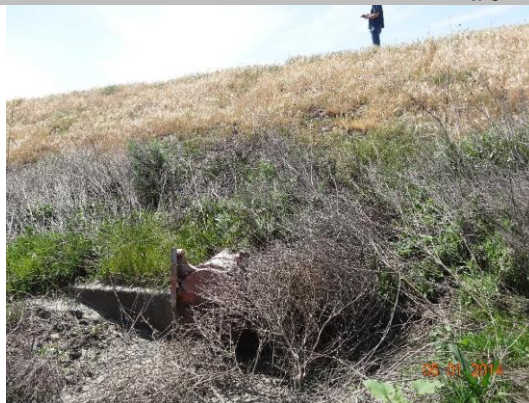
Photo 3 of 3 : UCIP\_SP\_2018\_39364\_66159.jpg

Comment Code						
Inspector Comment						
FS_ID:39364						
DS_ID:19667						
EP_NO: N/A						
Repair Type: Non-Urgent						
Crossing Status: Found						
UCIP Comments: Signs of erosion or sink hole present on landward toe--Need to contact owner. Dense vegetation limits the inspector's visibility to identify signs of pipe failure (leaks) along the slope.						
Recommend removing vegetation along pipe alignment to conduct proper inspection of structure.						
FIELD_STRUCT_DESC: 24-inch corrugated metal gravity drainage pipe through the levee, 8.6 feet below the crown. Flap gate on the waterside (WS) end. Brass cap No. 130 bench mark (BM) on the headwall on the landside (LS). [Additional Reference(s): DWR Levee Log, 2002. USACE San Joaquin O&M Manual 601.1, 1967, (HLM 3.95)].						
FS Date: 5/1/2014

Flap gate and concrete headwall visible through dense vegetation.

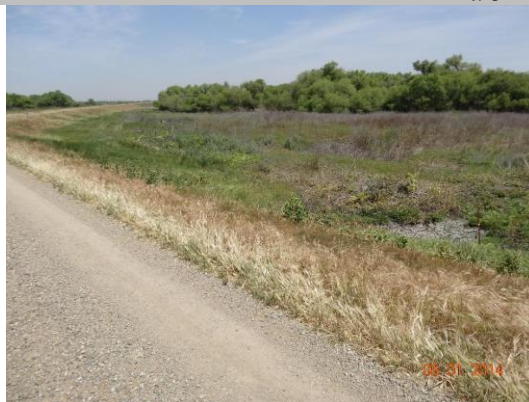
Photo 1 of 3 : UCIP\_SP\_2018\_36517\_66167.jpg

Comment Code						
Inspector Comment						
FS_ID:36517 DS_ID:19668 EP_NO: N/A Repair Type: Non-Urgent Crossing Status: Found UCIP Comments: Dense vegetation limits the inspector's visibility to identify signs of pipe failure (leaks) along the slope. Recommend removing vegetation along pipe alignment to conduct proper inspection of structure. FIELD_STRUCT_DESC: 24-inch corrugated metal gravity drainage pipe through the levee, 8 feet below the crown. Flap gate on the waterside (WS) end. Brass cap No. 125 bench mark (BM) on the headwall on the landside (LS). [Additional Reference(s): DWR Levee Log, 2002. USACE San Joaquin O&M Manual 601.1, 1967, (HLM 5.43)]. FS Date: 5/1/2014

View of waterward side.

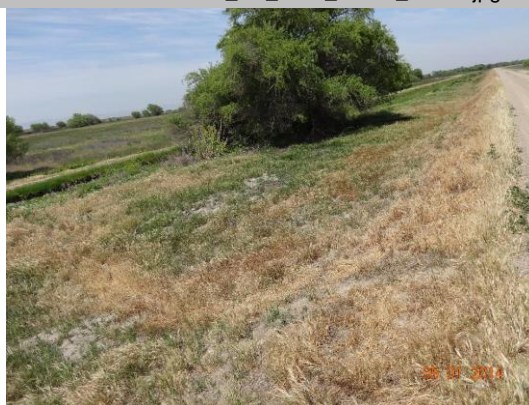
Photo 1 of 2 : UCIP\_SP\_2018\_36518\_66171.jpg

Comment Code					
Inspector Comment					
FS_ID:36518 DS_ID:19669 EP_NO: N/A Repair Type: Non-Urgent Crossing Status: Found UCIP Comments: Dense vegetation limits the inspector's visibility to identify signs of pipe failure (leaks) along the slope. Recommend removing vegetation along pipe alignment to conduct proper inspection of structure. FIELD_STRUCT_DESC: 24-inch corrugated metal gravity drainage pipe through the levee, 7.7 feet below the crown. Flap gate on the waterside (WS) end. Brass cap No. 125 bench mark (BM) on the headwall on the landside (LS). [Additional Reference(s): DWR Levee Log, 2002. USACE San Joaquin O&M Manual 601.1, 1967, (HLM 6.06)]. FS Date: 5/1/2014

View of landward side.

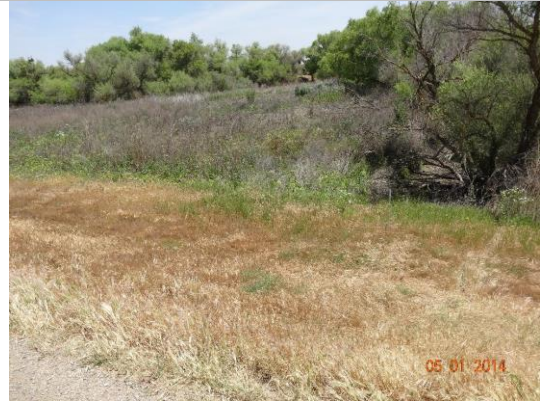
Photo 2 of 2 : UCIP\_SP\_2018\_36518\_66170.jpg

Comment Code						
Inspector Comment						
FS_ID:36518						
DS_ID:19669						
EP_NO: N/A						
Repair Type: Non-Urgent						
Crossing Status: Found						
UCIP Comments: Dense vegetation limits the inspector's visibility to identify signs of pipe failure (leaks) along the slope. Recommend removing vegetation along pipe alignment to conduct proper inspection of structure.						
FIELD_STRUCT_DESC: 24-inch corrugated metal gravity drainage pipe through the levee, 7.7 feet below the crown. Flap gate on the waterside (WS) end. Brass cap No. 125 bench mark (BM) on the headwall on the landside (LS). [Additional Reference(s): DWR Levee Log, 2002. USACE San Joaquin O&M Manual 601.1, 1967, (HLM 6.06)].						
FS Date: 5/1/2014

View of waterward side.

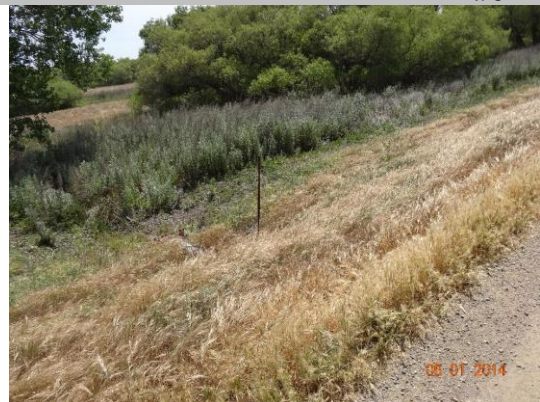
Photo 1 of 3 : UCIP\_SP\_2018\_36519\_66173.jpg

Comment Code						
Inspector Comment						
FS_ID:36519 DS_ID:19670 EP_NO: N/A Repair Type: Non-Urgent Crossing Status: Found UCIP Comments: Dense vegetation limits the inspector's visibility to identify signs of pipe failure (leaks) along the slope. Recommend removing vegetation along pipe alignment to conduct proper inspection of structure. FIELD_STRUCT_DESC: 24-inch corrugated metal gravity drainage pipe through the levee, 7.7 feet below the crown. Flap gate on the waterside (WS) end. Brass cap No. 125 bench mark (BM) on the headwall on the landside (LS). [Additional Reference(s): DWR Levee Log, 2002. USACE San Joaquin O&M Manual 601.1, 1967, (HLM 6.50)]. FS Date: 5/1/2014

View of waterward side.

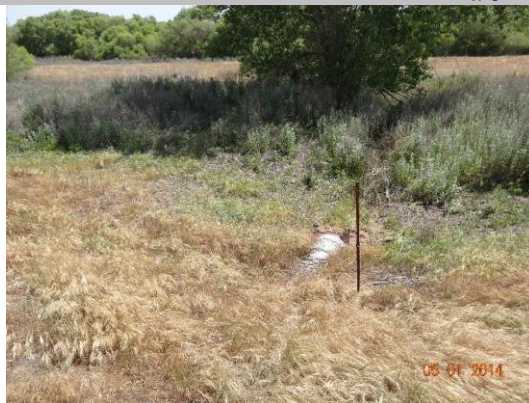
Photo 2 of 3 : UCIP\_SP\_2018\_36519\_66172.jpg

Comment Code						
Inspector Comment						
FS_ID:36519 DS_ID:19670 EP_NO: N/A Repair Type: Non-Urgent Crossing Status: Found UCIP Comments: Dense vegetation limits the inspector's visibility to identify signs of pipe failure (leaks) along the slope. Recommend removing vegetation along pipe alignment to conduct proper inspection of structure. FIELD_STRUCT_DESC: 24-inch corrugated metal gravity drainage pipe through the levee, 7.7 feet below the crown. Flap gate on the waterside (WS) end. Brass cap No. 125 bench mark (BM) on the headwall on the landside (LS). [Additional Reference(s): DWR Levee Log, 2002. USACE San Joaquin O&M Manual 601.1, 1967, (HLM 6.50)]. FS Date: 5/1/2014

Crossing and flap gate visible on waterward side.

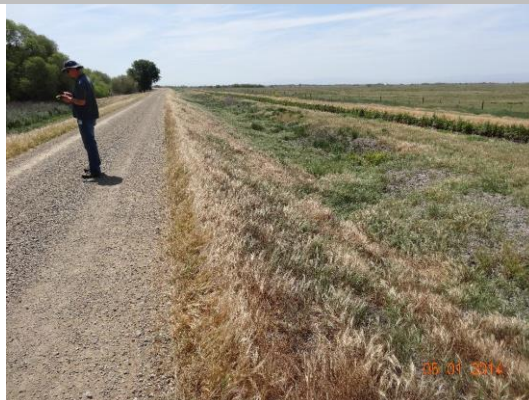
Photo 3 of 3 : UCIP\_SP\_2018\_36519\_66174.jpg

Overview of levee crown and landward slope.

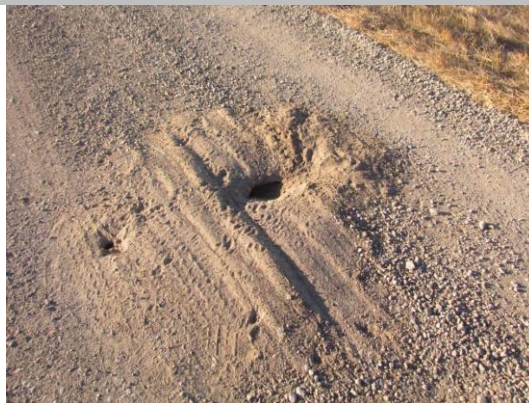
Photo 1 of 2 : SP\_2018\_NA0010\_119\_22\_20180307\_00009.jpg

LM Start	6.85	Rating **	M	Issue No.	22
LM End	6.85	Issue Type +	Ma	Location *	CR
Category	Earthen Levee			GPS Latitude/Longitude	
				Start	End
Item	Animal Control			37.242833 °	37.242833 °
				-120.822270 °	-120.822270 °
DWR ID	DWR_NA0010_02A_f_2016_22				
Comment Code					
A1 : Exterminate rodents and backfill and compact or grout burrows.					
Inspector Comment					
Noticed several burrow holes on the levee crown. It does not seem to be rodent holes or gopher holes. It could be moles.

Looking at rodent hole on levee crown.

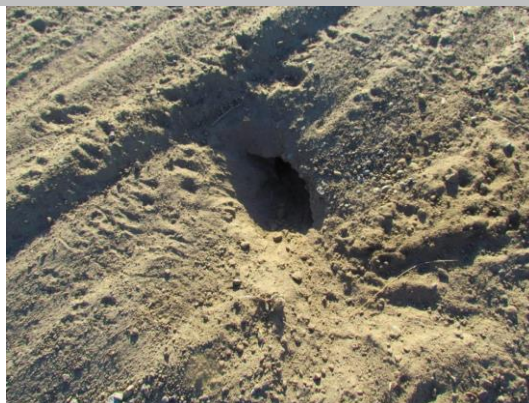
Photo 2 of 2 : SP\_2018\_NA0010\_119\_22\_20180307\_00010.jpg

Looking at close-up of rodent hole on levee crown.

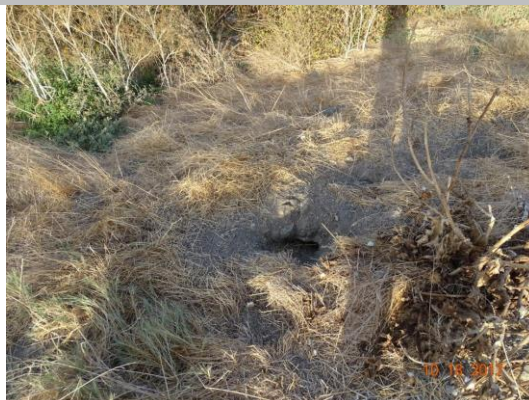
Photo 1 of 1 : SP\_2018\_NA0010\_119\_28\_20180307\_00015.jpg

LM Start	6.97	Rating **	M	Issue No.	28
LM End	6.97	Issue Type +	Ma	Location *	LS
Category	Earthen Levee			GPS Latitude/Longitude	
				Start	End
Item	Animal Control			37.241125 °	37.241125 °
				-120.821747 °	-120.821747 °
DWR ID	DWR_NA0010_02A_f_2017_28				
Comment Code					
A3 : No rodents visible, but rodent burrows visible; need to backfill and compact or grout burrows.					
Inspector Comment

Looking northwest at landside slope.
