**Flood Control Project Maintenance  
Levee Inspections**  
**LMA District Cover Sheet**  
**Spring 2018 Levee Inspection Results**

**Lower San Joaquin Levee District**

**Spring 2018 Levee Inspection Results**

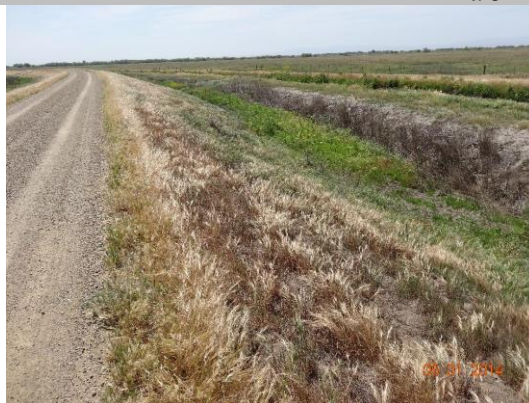
Photo 1 of 3 : UCIP\_SP\_2018\_39365\_66178.jpg

Comment Code					
Inspector Comment					
FS_ID:39365 DS_ID:19671 EP_NO: N/A Repair Type: Non-Urgent Crossing Status: Found UCIP Comments: Dense vegetation limits the inspector's visibility to identify signs of pipe failure (leaks) along the slope. Recommend removing vegetation along pipe alignment to conduct proper inspection of structure. Pipe extension visible on landward side--need to contact owner for additional information about extension/modification. FIELD_STRUCT_DESC: 24-inch corrugated metal gravity drainage pipe through the levee, 12.6 feet below the crown. Flap gate on the waterside (WS) end. Brass cap No. 125 bench mark (BM) on the headwall on the landside (LS). [Additional Reference(s): DWR Levee Log, 2002. USACE San Joaquin O&M Manual 601.1, 1967, (HLM 7.05)]. FS Date: 5/1/2014

View of landward side.

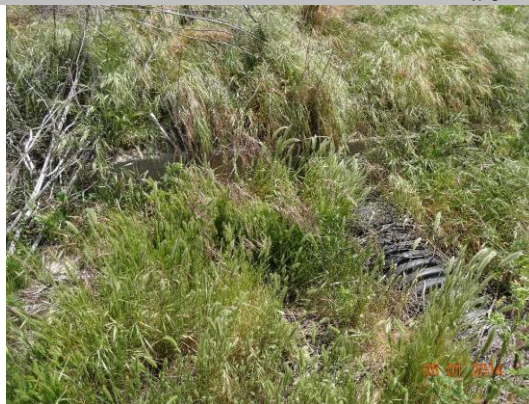
Photo 2 of 3 : UCIP\_SP\_2018\_39365\_66177.jpg

Pipe extension visible on landward side attached to inlet at concrete headwall.

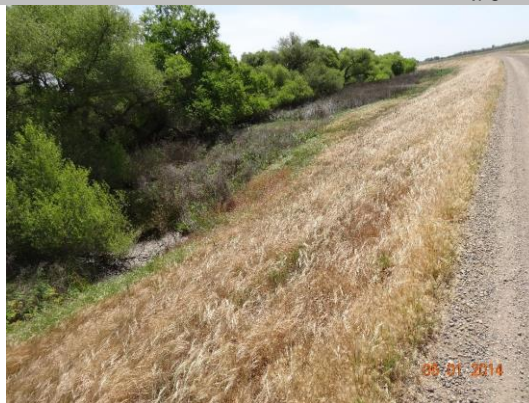
Photo 3 of 3 : UCIP\_SP\_2018\_39365\_66176.jpg

Comment Code						
Inspector Comment						
FS_ID:39365 DS_ID:19671 EP_NO: N/A Repair Type: Non-Urgent Crossing Status: Found UCIP Comments: Dense vegetation limits the inspector's visibility to identify signs of pipe failure (leaks) along the slope. Recommend removing vegetation along pipe alignment to conduct proper inspection of structure. Pipe extension visible on landward side--need to contact owner for additional information about extension/modification. FIELD_STRUCT_DESC: 24-inch corrugated metal gravity drainage pipe through the levee, 12.6 feet below the crown. Flap gate on the waterside (WS) end. Brass cap No. 125 bench mark (BM) on the headwall on the landside (LS). [Additional Reference(s): DWR Levee Log, 2002. USACE San Joaquin O&M Manual 601.1, 1967, (HLM 7.05)]. FS Date: 5/1/2014

View of waterward side.

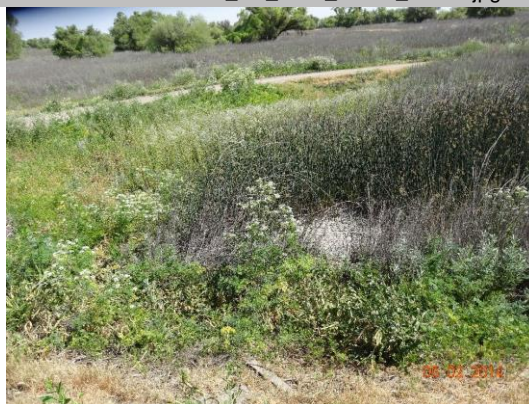
Photo 1 of 3 : UCIP\_SP\_2018\_36521\_66183.jpg

Comment Code					
Inspector Comment					
FS_ID:36521 DS_ID:19673 EP_NO: N/A Repair Type: Non-Urgent Crossing Status: Found UCIP Comments: Dense vegetation limits the inspector's visibility to identify signs of pipe failure (leaks) along the slope. Recommend removing vegetation along pipe alignment to conduct proper inspection of structure. FIELD_STRUCT_DESC: 24-inch corrugated metal gravity drainage pipe through the levee, 8 feet below the crown. Flap gate on the waterside (WS) end. Brass cap No. 125 bench mark (BM) on the headwall on the landside (LS). [Additional Reference(s): DWR Levee Log, 2002. USACE San Joaquin O&M Manual 601.1, 1967, (HLM 7.77)]. FS Date: 5/1/2014

View of waterward side.

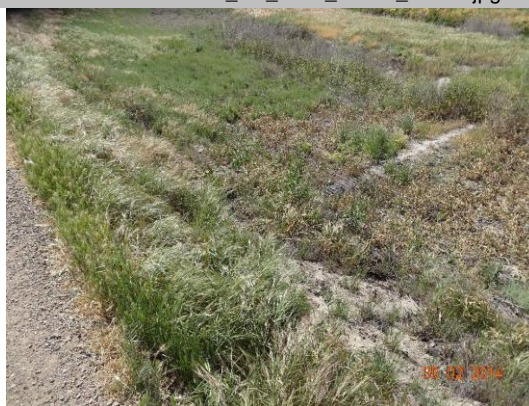
Photo 2 of 3 : UCIP\_SP\_2018\_36521\_66182.jpg

Comment Code						
Inspector Comment						
FS_ID:36521 DS_ID:19673 EP_NO: N/A Repair Type: Non-Urgent Crossing Status: Found UCIP Comments: Dense vegetation limits the inspector's visibility to identify signs of pipe failure (leaks) along the slope. Recommend removing vegetation along pipe alignment to conduct proper inspection of structure. FIELD_STRUCT_DESC: 24-inch corrugated metal gravity drainage pipe through the levee, 8 feet below the crown. Flap gate on the waterside (WS) end. Brass cap No. 125 bench mark (BM) on the headwall on the landside (LS). [Additional Reference(s): DWR Levee Log, 2002. USACE San Joaquin O&M Manual 601.1, 1967, (HLM 7.77)]. FS Date: 5/1/2014

View of landward side.

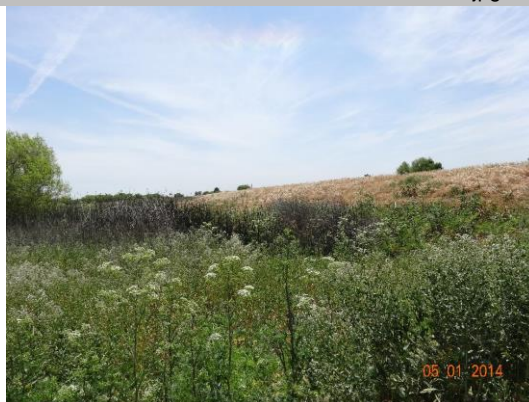
Photo 3 of 3 : UCIP\_SP\_2018\_36521\_66181.jpg

View of waterward side--photo taken from levee toe looking towards alignment of crossing.

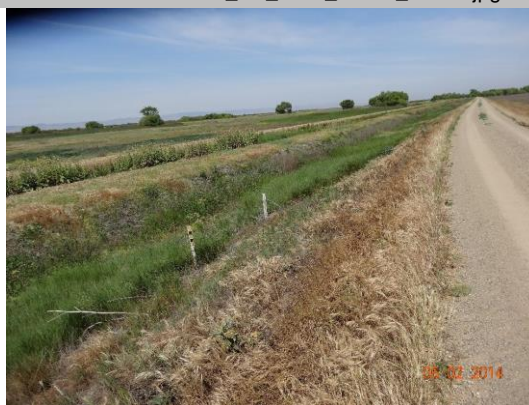
Photo 1 of 3 : UCIP\_SP\_2018\_39366\_66184.jpg

Comment Code					
Inspector Comment					
FS_ID:39366					
DS_ID:19674					
EP_NO: N/A					
Repair Type: Non-Urgent					
Crossing Status: Found					
UCIP Comments: Dense vegetation limits the inspector's visibility to identify signs of pipe failure (leaks) along the slope and landward headwall. Recommend removing vegetation along pipe alignment and toe to conduct proper inspection of structure. Sediment buildup in pipe visible from landward side--recommend clearing.					
FIELD_STRUCT_DESC: 24-inch corrugated metal gravity drainage pipe through the levee, 9 feet below the crown. Flap gate on the waterside (WS) end. Brass cap No. 120 bench mark (BM) on the headwall on the landside (LS). [Additional Reference(s): DWR Levee Log, 2002. USACE San Joaquin O&M Manual 601.1, 1967, (HLM 8.16)].					
FS Date: 5/14/2014

View of landward side.

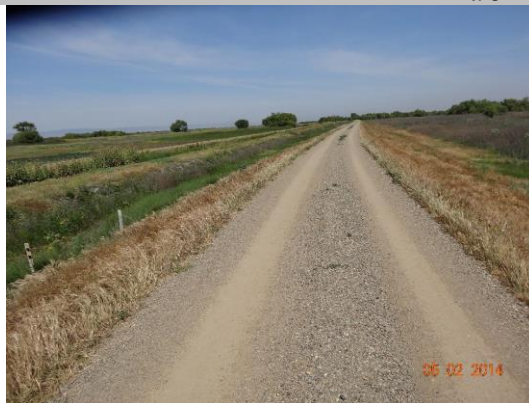
Photo 2 of 3 : UCIP\_SP\_2018\_39366\_66185.jpg

Comment Code						
Inspector Comment						
FS_ID:39366						
DS_ID:19674						
EP_NO: N/A						
Repair Type: Non-Urgent						
Crossing Status: Found						
UCIP Comments: Dense vegetation limits the inspector's visibility to identify signs of pipe failure (leaks) along the slope and landward headwall. Recommend removing vegetation along pipe alignment and toe to conduct proper inspection of structure. Sediment buildup in pipe visible from landward side--recommend clearing.						
FIELD_STRUCT_DESC: 24-inch corrugated metal gravity drainage pipe through the levee, 9 feet below the crown. Flap gate on the waterside (WS) end. Brass cap No. 120 bench mark (BM) on the headwall on the landside (LS). [Additional Reference(s): DWR Levee Log, 2002. USACE San Joaquin O&M Manual 601.1, 1967, (HLM 8.16)].						
FS Date: 5/14/2014

Overview of levee crown at crossing.

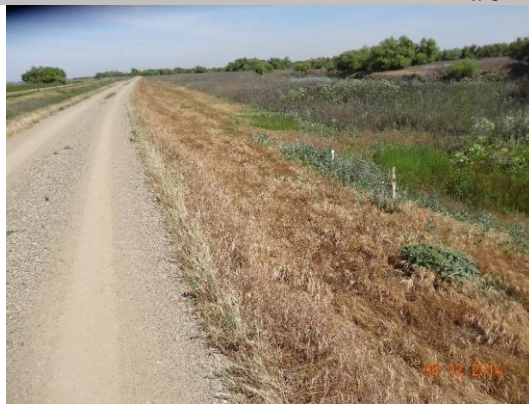
Photo 3 of 3 : UCIP\_SP\_2018\_39366\_66186.jpg

View of waterward side.

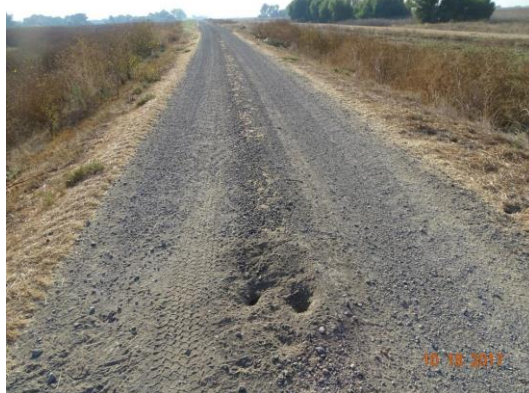
Photo 1 of 1 : SP\_2018\_NA0010\_120\_15\_20180307\_00004.jpg

LM Start	8.14	Rating **	M	Issue No.	15
LM End	8.14	Issue Type +	Ma	Location *	CR
Category	Earthen Levee			GPS Latitude/Longitude	
				Start	End
Item	Animal Control			37.228224 °	37.228224 °
				-120.808622 °	-120.808622 °
DWR ID	DWR_NA0010_02B_f_2017_15				
Comment Code					
A3 : No rodents visible, but rodent burrows visible; need to backfill and compact or grout burrows.					
Inspector Comment					
Several rodent holes on the crown.

Looking southeast at the crown.

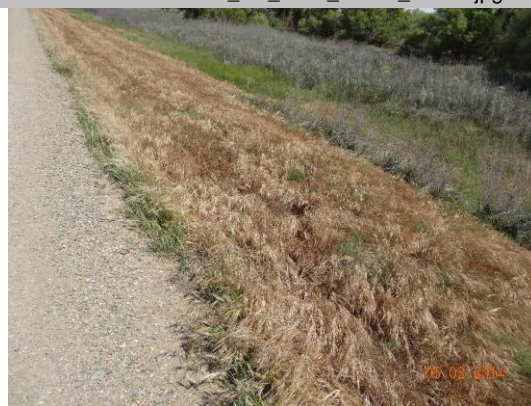
Photo 2 of 3 : UCIP\_SP\_2018\_42503\_66199.jpg

Comment Code						
Inspector Comment						
FS_ID:42503 DS_ID:19676 EP_NO: N/A Repair Type: Non-Urgent Crossing Status: Found UCIP Comments: Dense vegetation limits the inspector's visibility to identify signs of pipe failure (leaks) along the slope. Recommend removing vegetation along pipe alignment to conduct proper inspection of structure. Burrow activity presen on waterward slope. FIELD_STRUCT_DESC: 24-inch corrugated metal gravity drainage pipe through the levee, 8.8 feet below the crown. Flap gate on the waterside (WS) end. Brass cap No. 120 bench mark (BM) on the headwall on the landside (LS). [Additional Reference(s): DWR Levee Log, 2002. USACE San Joaquin O&M Manual 601.1, 1967, (HLM 8.86)]. FS Date: 5/14/2014

View of waterward side.

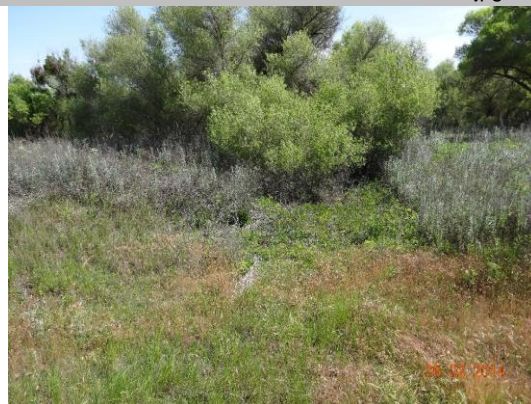
Photo 3 of 3 : UCIP\_SP\_2018\_42503\_66201.jpg

View of waterward toe.

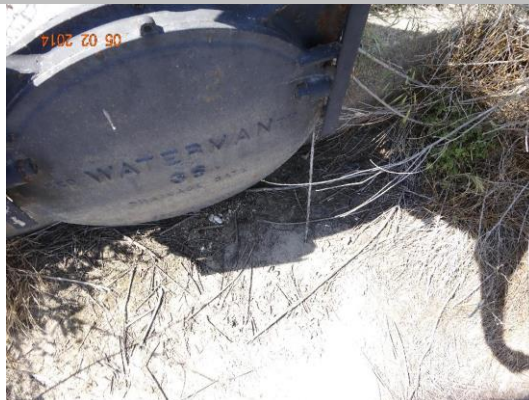
Photo 2 of 3 : UCIP\_SP\_2018\_36525\_66207.jpg

Comment Code					
Inspector Comment					
FS_ID:36525 DS_ID:19677 EP_NO: N/A Repair Type: Non-Urgent Crossing Status: Found UCIP Comments: Dense vegetation limits the inspector's visibility to identify signs of pipe failure (leaks) along the slope. Recommend removing vegetation along pipe alignment to conduct proper inspection of structure. FIELD_STRUCT_DESC: 36-inch corrugated metal gravity drainage pipe through the levee, 8.8 feet below the crown. Flap gate on the waterside (WS) end. Brass cap No. 120 bench mark (BM) on the headwall on the landside (LS). [Additional Reference(s): DWR Levee Log, 2002. USACE San Joaquin O&M Manual 601.1, 1967, (HLM 9.02)]. FS Date: 5/14/2014

View of flap gate visible from waterward side.

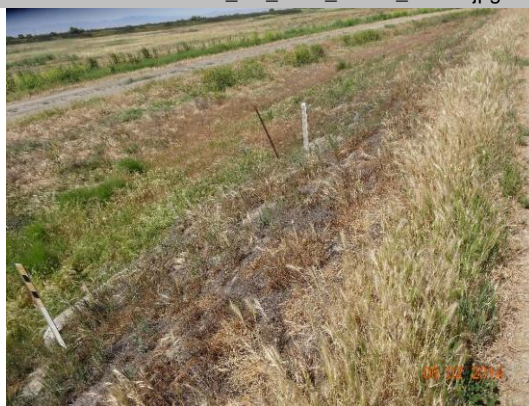
Photo 3 of 3 : UCIP\_SP\_2018\_36525\_66206.jpg

Comment Code						
Inspector Comment						
FS_ID:36525 DS_ID:19677 EP_NO: N/A Repair Type: Non-Urgent Crossing Status: Found UCIP Comments: Dense vegetation limits the inspector's visibility to identify signs of pipe failure (leaks) along the slope. Recommend removing vegetation along pipe alignment to conduct proper inspection of structure. FIELD_STRUCT_DESC: 36-inch corrugated metal gravity drainage pipe through the levee, 8.8 feet below the crown. Flap gate on the waterside (WS) end. Brass cap No. 120 bench mark (BM) on the headwall on the landside (LS). [Additional Reference(s): DWR Levee Log, 2002. USACE San Joaquin O&M Manual 601.1, 1967, (HLM 9.02)]. FS Date: 5/14/2014

View of landward side.

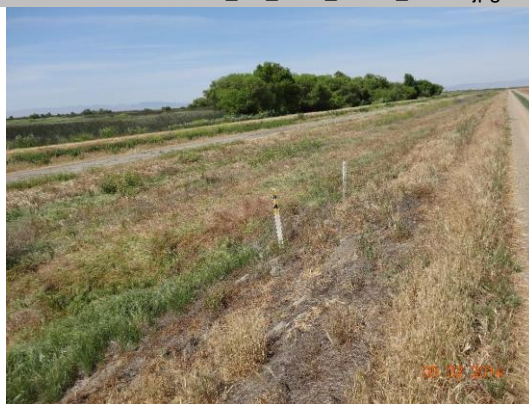
Photo 1 of 3 : UCIP\_SP\_2018\_40443\_66211.jpg

Comment Code						
Inspector Comment						
FS_ID:40443 DS_ID:19678 EP_NO: N/A Repair Type: Non-Urgent Crossing Status: Found UCIP Comments: Dense vegetation limits the inspector's visibility to identify signs of pipe failure (leaks) along the slope. Recommend removing vegetation along pipe alignment to conduct proper inspection of structure. FIELD_STRUCT_DESC: 24-inch corrugated metal gravity drainage pipe through the levee, 8 feet below the crown. Flap gate on the waterside (WS) end. Brass cap No. 120 bench mark (BM) on the headwall on the landside (LS). [Additional Reference(s): DWR Levee Log, 2002. USACE San Joaquin O&M Manual 601.1, 1967, (HLM 9.20)]. FS Date: 5/14/2014

View of landward side.

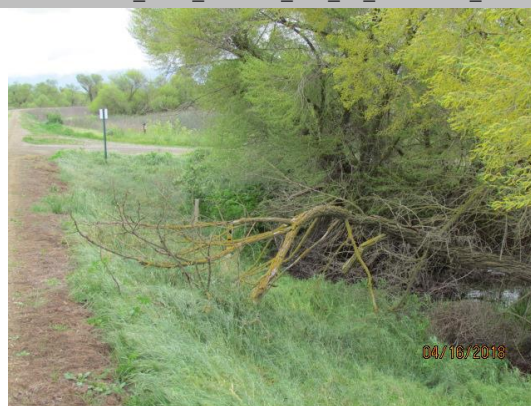
Photo 1 of 1 : SP\_2018\_NA0010\_120\_17\_20180419\_00046.jpg

LM Start	9.42	Rating **	M	Issue No.	17
LM End	9.42	Issue Type +	Ma	Location *	LS
Category	Earthen Levee			GPS Latitude/Longitude	
				Start	End
Item	Trim / Thin Trees			37.220199°	37.220199°
				-120.788748°	-120.788748°
DWR ID	DWR_NA0010_02B_f_2016_17				
Comment Code					
T1 : Trim trees to at least five feet above ground level.					
Inspector Comment					
Trim back dead tree limbs on landside toe.

Looking north at broken tree limbs and branches on landward slope.  
(Spring 2018)

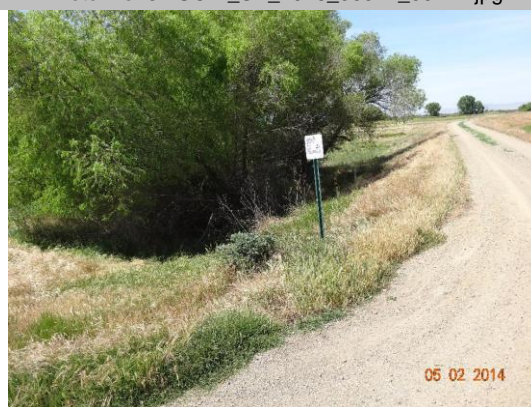
Photo 1 of 3 : UCIP\_SP\_2018\_36527\_66217.jpg

Comment Code						
Inspector Comment						
FS_ID:36527 DS_ID:19686 EP_NO: N/A Repair Type: Non-Urgent Crossing Status: Found UCIP Comments: Dense vegetation limits the inspector's visibility to identify signs of pipe failure (leaks) along the slope. Recommend removing vegetation along pipe alignment to conduct proper inspection of structure. FIELD_STRUCT_DESC: 24-inch corrugated metal gravity drainage pipe through the levee, 9 feet below the crown. Flap gate on the waterside (WS) end. Brass cap No. 115 bench mark (BM) on the headwall on the landside (LS). [Additional Reference(s): DWR Levee Log, 2002. USACE San Joaquin O&M Manual 601.1, 1967, (HLM 9.46)]. FS Date: 5/14/2014

View of landward side.

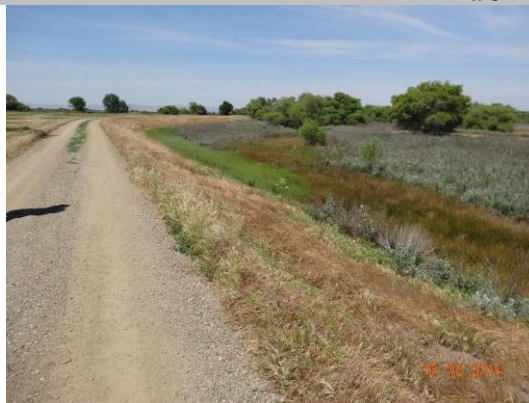
Photo 2 of 3 : UCIP\_SP\_2018\_36527\_66216.jpg

Comment Code						
Inspector Comment						
FS_ID:36527						
DS_ID:19686						
EP_NO: N/A						
Repair Type: Non-Urgent						
Crossing Status: Found						
UCIP Comments: Dense vegetation limits the inspector's visibility to identify signs of pipe failure (leaks) along the slope. Recommend removing vegetation along pipe alignment to conduct proper inspection of structure.						
FIELD_STRUCT_DESC: 24-inch corrugated metal gravity drainage pipe through the levee, 9 feet below the crown. Flap gate on the waterside (WS) end. Brass cap No. 115 bench mark (BM) on the headwall on the landside (LS). [Additional Reference(s): DWR Levee Log, 2002. USACE San Joaquin O&M Manual 601.1, 1967, (HLM 9.46)].						
FS Date: 5/14/2014

View of waterward side.

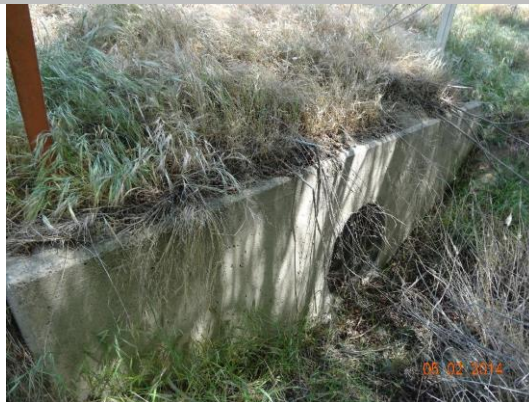
Photo 3 of 3 : UCIP\_SP\_2018\_36527\_66215.jpg

Concrete headwall visible on landward side.

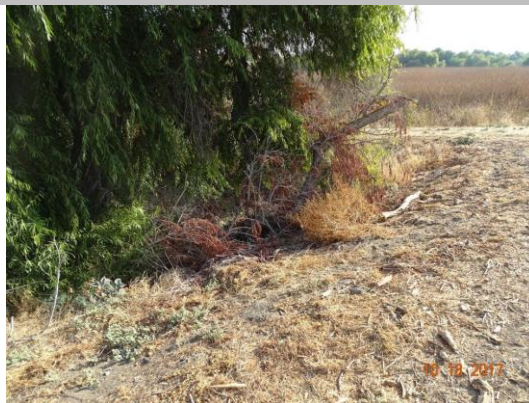
Photo 1 of 1 : SP\_2018\_NA0010\_120\_18\_20180307\_00005.jpg

LM Start	9.60	Rating **	M	Issue No.	18
LM End	9.60	Issue Type +	Ma	Location *	WS
Category	Earthen Levee			GPS Latitude/Longitude	
				Start	End
Item	Encroachments			37.220794 °	37.220794 °
				-120.785721 °	-120.785721 °
DWR ID	DWR_NA0010_02B_f_2017_18				
Comment Code					
TR : Tree or limb					
Inspector Comment

Looking southeast at waterside slope.

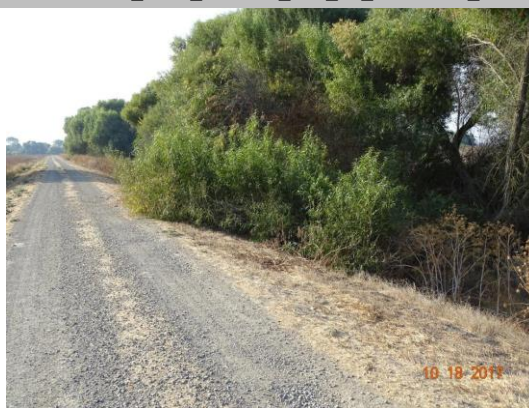
Photo 1 of 2 : SP\_2018\_NA0010\_120\_23\_20180307\_00009.jpg

LM Start	9.75	Rating **	U	Issue No.	23
LM End	9.75	Issue Type +	Ma	Location *	LS
Category	Earthen Levee			GPS Latitude/Longitude	
				Start	End
Item	Trim / Thin Trees			37.219083 °	37.219083 °
				-120.784327 °	-120.784327 °
DWR ID	DWR_NA0010_02B_s_2017_23				
Comment Code					
T1 : Trim trees to at least five feet above ground level.					
Inspector Comment

Looking south at landside slope.

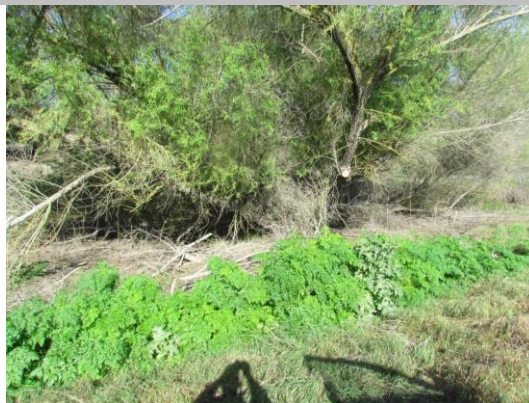
Photo 2 of 2 : SP\_2018\_NA0010\_120\_23\_20180307\_00010.jpg

Looking west at untrimmed trees at landward toe.

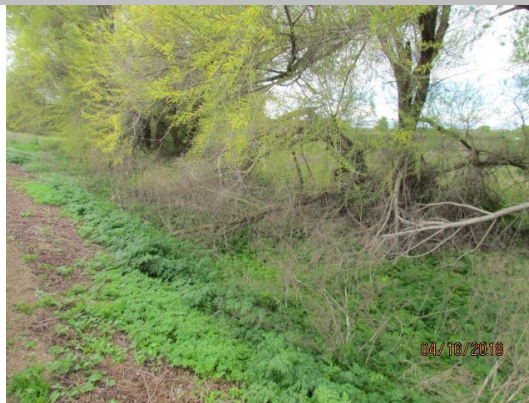
Photo 1 of 1 : SP\_2018\_NA0010\_120\_24\_20180419\_00047.jpg

LM Start	9.83	Rating **	M	Issue No.	24
LM End	9.83	Issue Type +	Ma	Location *	LS
Category	Earthen Levee			GPS Latitude/Longitude	
				Start	End
Item	Encroachments			37.218037 °	37.218037 °
				-120.784199 °	-120.784199 °
DWR ID	DWR_NA0010_02B_s_2018_24				
Comment Code					
TR : Tree or limb					
Inspector Comment					
Remove dead tree limbs and branches for landward berm.

Looking west at dead tree limbs and branches on landward slope.  
(Spring 2018)

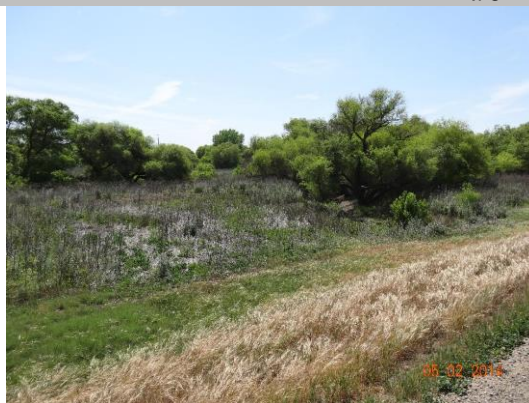
Photo 1 of 3 : UCIP\_SP\_2018\_36528\_66224.jpg

Comment Code					
Inspector Comment					
FS_ID:36528					
DS_ID:19687					
EP_NO: N/A					
Repair Type: Non-Urgent					
Crossing Status: Found					
UCIP Comments: Dense vegetation limits the inspector's visibility to identify signs of pipe failure (leaks) along the slope. Recommend removing vegetation along pipe alignment to conduct proper inspection of structure.					
FIELD_STRUCT_DESC: 24-inch corrugated metal gravity drainage pipe through the levee, 11.7 feet below the crown. Flap gate on the waterside (WS) end. Brass cap No. 115 bench mark (BM) on the headwall on the landside (LS). [Additional Reference(s): DWR Levee Log, 2002. USACE San Joaquin O&M Manual 601.1, 1967, (HLM 10.12)].					
FS Date: 5/14/2014

Overview of waterward side.

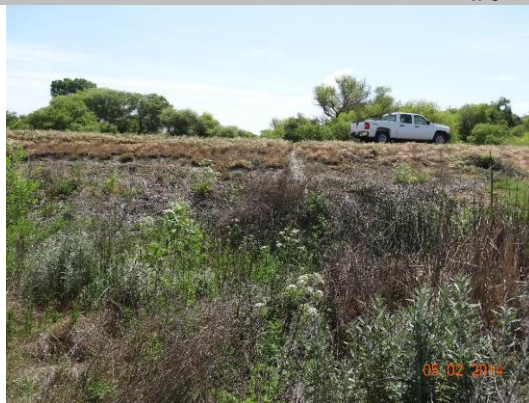
Photo 2 of 3 : UCIP\_SP\_2018\_36528\_66226.jpg

Item	DWR UCIP LMA Responsibility			37.214229 °	37.214229 °	
				-120.784350 °	-120.784350 °	
DWR ID						
Comment Code						
Inspector Comment						
FS_ID:36528 DS_ID:19687 EP_NO: N/A Repair Type: Non-Urgent Crossing Status: Found UCIP Comments: Dense vegetation limits the inspector's visibility to identify signs of pipe failure (leaks) along the slope. Recommend removing vegetation along pipe alignment to conduct proper inspection of structure. FIELD_STRUCT_DESC: 24-inch corrugated metal gravity drainage pipe through the levee, 11.7 feet below the crown. Flap gate on the waterside (WS) end. Brass cap No. 115 bench mark (BM) on the headwall on the landside (LS). [Additional Reference(s): DWR Levee Log, 2002. USACE San Joaquin O&M Manual 601.1, 1967, (HLM 10.12)]. FS Date: 5/14/2014

View of waterward slope.

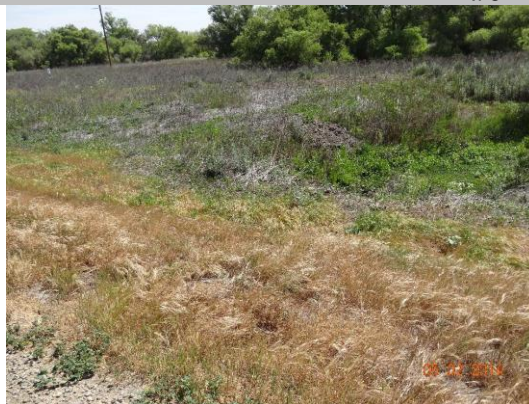
Photo 3 of 3 : UCIP\_SP\_2018\_36528\_66222.jpg

View of waterward side.

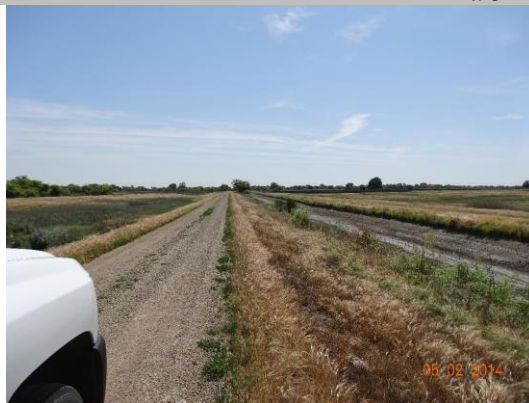
Photo 1 of 3 : UCIP\_SP\_2018\_42504\_66231.jpg

Comment Code					
Inspector Comment					
FS_ID:42504 DS_ID:19688 EP_NO: N/A Repair Type: Non-Urgent Crossing Status: Found UCIP Comments: Dense vegetation limits the inspector's visibility to identify signs of pipe failure (leaks) along the slope. Recommend removing vegetation along pipe alignment to conduct proper inspection of structure. Sediment buildup in pipe visible on landward side--recommend clearing. FIELD_STRUCT_DESC: 24-inch corrugated metal gravity drainage pipe through the levee, 8 feet below the crown. Flap gate on the waterside (WS) end. Brass cap No. 115 bench mark (BM) on the headwall on the landside (LS). [Additional Reference(s): DWR Levee Log, 2002. USACE San Joaquin O&M Manual 601.1, 1967, (HLM 10.81)]. FS Date: 5/14/2014

View of landward side.

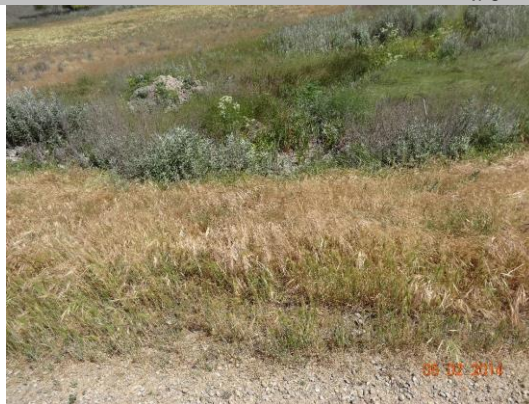
Photo 2 of 3 : UCIP\_SP\_2018\_42504\_66232.jpg

View of waterward side.

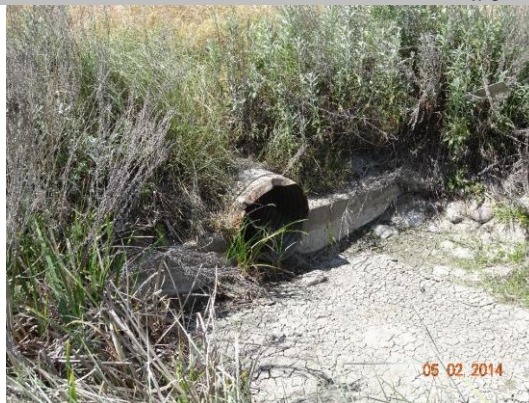
Photo 3 of 3 : UCIP\_SP\_2018\_42504\_66234.jpg

Item	DWR UCIP LMA Responsibility			37.206352 °	37.206352 °	
				-120.777634 °	-120.777634 °	
DWR ID						
Comment Code						
Inspector Comment						
FS_ID:42504						
DS_ID:19688						
EP_NO: N/A						
Repair Type: Non-Urgent						
Crossing Status: Found						
UCIP Comments: Dense vegetation limits the inspector's visibility to identify signs of pipe failure (leaks) along the slope. Recommend removing vegetation along pipe alignment to conduct proper inspection of structure. Sediment buildup in pipe visible on landward side--recommend clearing.						
FIELD_STRUCT_DESC: 24-inch corrugated metal gravity drainage pipe through the levee, 8 feet below the crown. Flap gate on the waterside (WS) end. Brass cap No. 115 bench mark (BM) on the headwall on the landside (LS). [Additional Reference(s): DWR Levee Log, 2002. USACE San Joaquin O&M Manual 601.1, 1967, (HLM 10.81)].						
FS Date: 5/14/2014

View of pipe visible on waterward side.

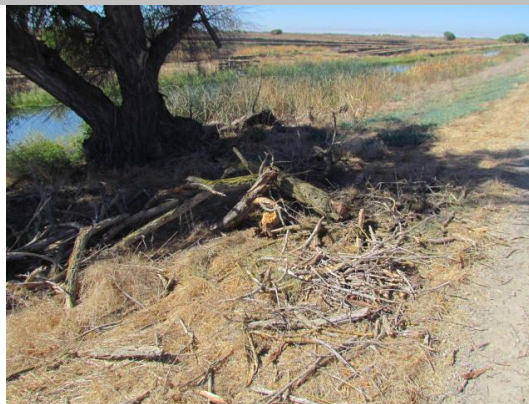
Photo 1 of 1 : SP\_2018\_NA0010\_120\_14\_20180307\_00003.jpg

LM Start	10.94	Rating **	M	Issue No.	14
LM End	10.94	Issue Type +	Ma	Location *	LS
Category	Earthen Levee			GPS Latitude/Longitude	
				Start	End
Item	Encroachments			37.205711 °	37.205711 °
				-120.774741 °	-120.774741 °
DWR ID	DWR_NA0010_02B_f_2015_14				
Comment Code					
PR : Prunings					
Inspector Comment					
Prunings on landside slope.

Looking at prunings on landward slope.

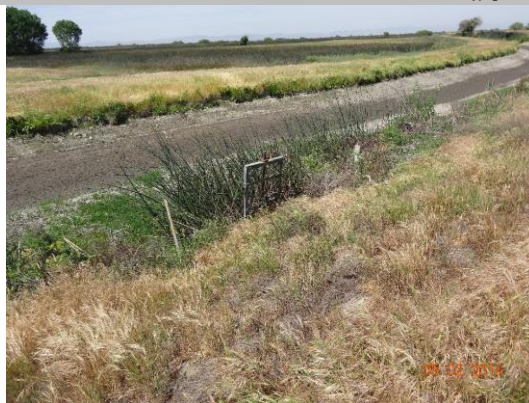
Photo 1 of 3 : UCIP\_SP\_2018\_36530\_66236.jpg

Comment Code					
Inspector Comment					
FS_ID:36530 DS_ID:19689 EP_NO: N/A Repair Type: Non-Urgent Crossing Status: Found UCIP Comments: Dense vegetation limits the inspector's visibility to identify signs of pipe failure (leaks) along the slope. Recommend removing vegetation along pipe alignment to conduct proper inspection of structure. FIELD_STRUCT_DESC: 24-inch corrugated metal gravity drainage pipe through the levee, 8 feet below the crown. Flap gate on the waterside (WS) end. Brass cap No. 115 bench mark (BM) on the headwall on the landside (LS). [Additional Reference(s): DWR Levee Log, 2002. USACE San Joaquin O&M Manual 601.1, 1967, (HLM 11.17)]. FS Date: 5/14/2014

View of landward slope.

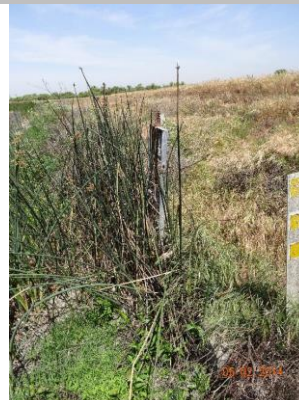
Photo 2 of 3 : UCIP\_SP\_2018\_36530\_66235.jpg

Slide gate visible on landward side blocked by vegetation.

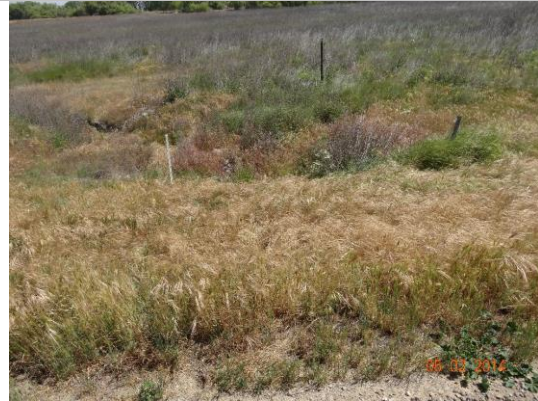
Photo 3 of 3 : UCIP\_SP\_2018\_36530\_66238.jpg

Item	DWR UCIP Field Study			37.204640 °	37.204640 °	
				-120.771564 °	-120.771564 °	
DWR ID						
Comment Code						
Inspector Comment						
FS_ID:36530 DS_ID:19689 EP_NO: N/A Repair Type: Non-Urgent Crossing Status: Found UCIP Comments: Dense vegetation limits the inspector's visibility to identify signs of pipe failure (leaks) along the slope. Recommend removing vegetation along pipe alignment to conduct proper inspection of structure. FIELD_STRUCT_DESC: 24-inch corrugated metal gravity drainage pipe through the levee, 8 feet below the crown. Flap gate on the waterside (WS) end. Brass cap No. 115 bench mark (BM) on the headwall on the landside (LS). [Additional Reference(s): DWR Levee Log, 2002. USACE San Joaquin O&M Manual 601.1, 1967, (HLM 11.17)]. FS Date: 5/14/2014

View of waterward side.

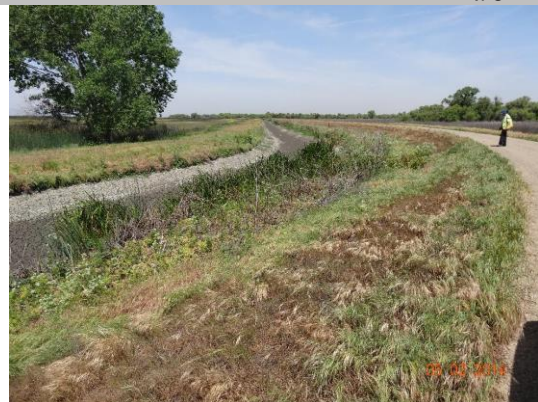
Photo 1 of 3 : UCIP\_SP\_2018\_36531\_66241.jpg

Comment Code						
Inspector Comment						
FS_ID:36531 DS_ID:19690 EP_NO: N/A Repair Type: Non-Urgent Crossing Status: Found UCIP Comments: Dense vegetation limits the inspector's visibility to identify signs of pipe failure (leaks) along the slope. Recommend removing vegetation along pipe alignment to conduct proper inspection of structure. FIELD_STRUCT_DESC: 24-inch corrugated metal gravity drainage pipe through the levee, 8 feet below the crown. Flap gate on the waterside (WS) end. Screw gate on the landside (LS). [Additional Reference(s): DWR Levee Log, 2002. USACE San Joaquin O&M Manual 601.1, 1967, (HLM 11.43)]. FS Date: 5/14/2014

View of landward side.

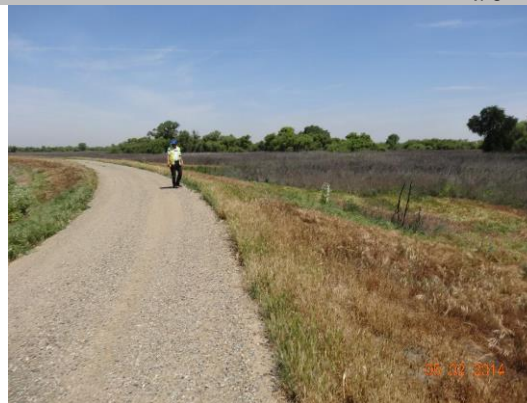
Photo 2 of 3 : UCIP\_SP\_2018\_36531\_66240.jpg

Item	DWR UCIP LMA Responsibility			37.201792 °		37.201792 °
				-120.768462 °		-120.768462 °
DWR ID						
Comment Code						
Inspector Comment						
FS_ID:36531 DS_ID:19690 EP_NO: N/A Repair Type: Non-Urgent Crossing Status: Found UCIP Comments: Dense vegetation limits the inspector's visibility to identify signs of pipe failure (leaks) along the slope. Recommend removing vegetation along pipe alignment to conduct proper inspection of structure. FIELD_STRUCT_DESC: 24-inch corrugated metal gravity drainage pipe through the levee, 8 feet below the crown. Flap gate on the waterside (WS) end. Screw gate on the landside (LS). [Additional Reference(s): DWR Levee Log, 2002. USACE San Joaquin O&M Manual 601.1, 1967, (HLM 11.43)]. FS Date: 5/14/2014

View of waterward side.

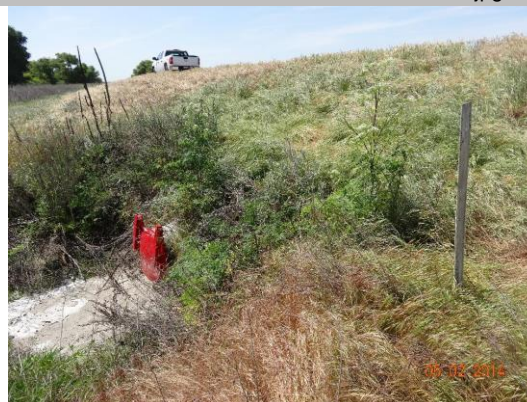
Photo 3 of 3 : UCIP\_SP\_2018\_36531\_66239.jpg

Flap gate visible on waterward toe.

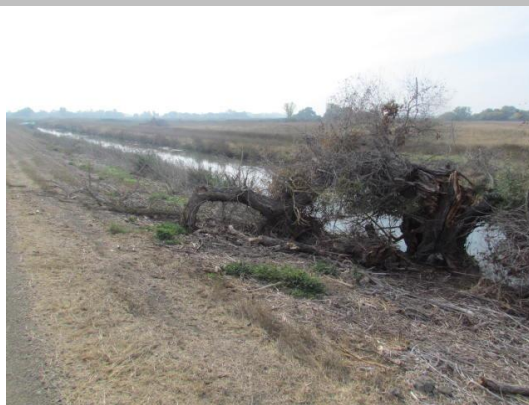
Photo 2 of 2 : SP\_2018\_NA0010\_120\_1\_20180307\_00002.jpg

Looking southwest at tree limb on waterward slope.

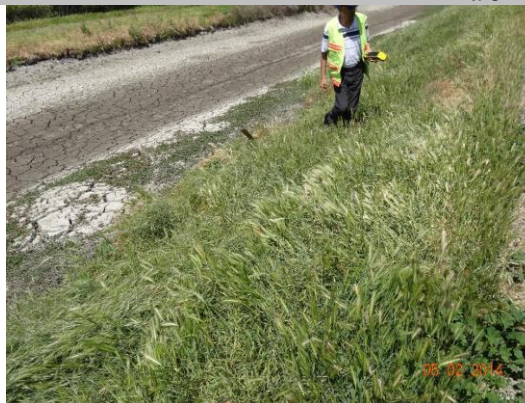
Photo 1 of 3 : UCIP\_SP\_2018\_39370\_66245.jpg

Comment Code					
Inspector Comment					
FS_ID:39370 DS_ID:19663 EP_NO: N/A Repair Type: Non-Urgent Crossing Status: Found UCIP Comments: Dense vegetation limits the inspector's visibility to identify signs of pipe failure (leaks) along the slope. Recommend removing vegetation along pipe alignment to conduct proper inspection of structure. Sediment buildup in pipe--recommend clearing. FIELD_STRUCT_DESC: 24-inch corrugated metal gravity drainage pipe through the levee, 6.5 feet below the crown. Slide gate in a pipe riser on the waterside (WS) slope. [Additional Reference(s): DWR Levee Log, 2002. USACE San Joaquin O&M Manual 601.1, 1967, (HLM 13.22)]. FS Date: 5/14/2014

View of landward side.

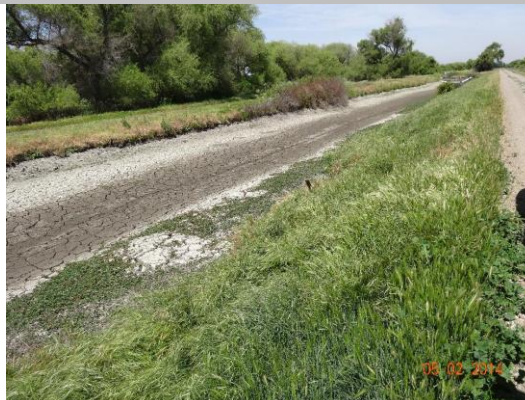
Photo 2 of 3 : UCIP\_SP\_2018\_39370\_66244.jpg

Overview of landward slope.

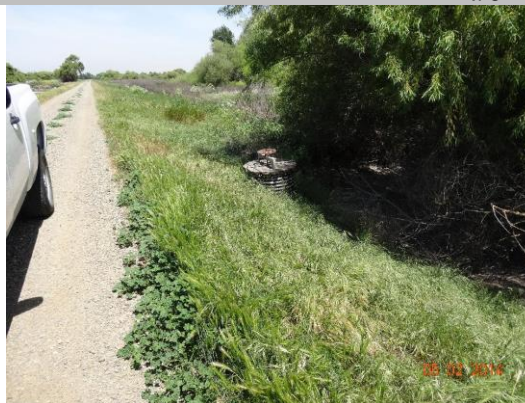
Photo 3 of 3 : UCIP\_SP\_2018\_39370\_66243.jpg

Item	DWR UCIP LMA Responsibility			37.179265 °		37.179265 °
				-120.764870 °		-120.764870 °
DWR ID						
Comment Code						
Inspector Comment						
FS_ID:39370 DS_ID:19663 EP_NO: N/A Repair Type: Non-Urgent Crossing Status: Found UCIP Comments: Dense vegetation limits the inspector's visibility to identify signs of pipe failure (leaks) along the slope. Recommend removing vegetation along pipe alignment to conduct proper inspection of structure. Sediment buildup in pipe--recommend clearing. FIELD_STRUCT_DESC: 24-inch corrugated metal gravity drainage pipe through the levee, 6.5 feet below the crown. Slide gate in a pipe riser on the waterside (WS) slope. [Additional Reference(s): DWR Levee Log, 2002. USACE San Joaquin O&M Manual 601.1, 1967, (HLM 13.22)]. FS Date: 5/14/2014

View of waterward side.

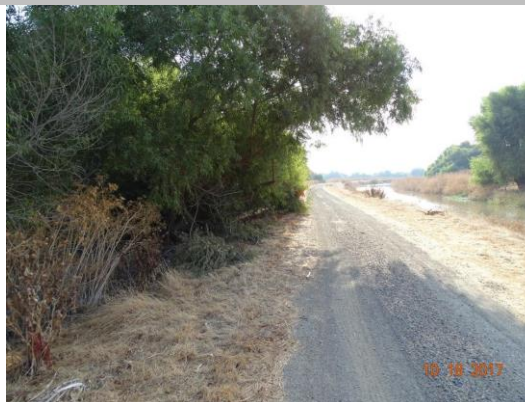
Photo 1 of 2 : SP\_2018\_NA0010\_120\_167\_20180307\_00011.jpg

LM Start	13.42	Rating **	U	Issue No.	167
LM End	13.42	Issue Type +	Ma	Location *	WS
Category	Earthen Levee			GPS Latitude/Longitude	
				Start	End
Item	Trim / Thin Trees			37.176379 °	37.176379 °
				-120.762255 °	-120.762255 °
DWR ID	DWR_NA0010_02B_s_2015_167				
Comment Code					
T3 : Trim and thin trees to allow visibility of the ground and room to flood fight.					
Inspector Comment					
Dense trees on waterside slope.

Looking southeast at waterside slope.

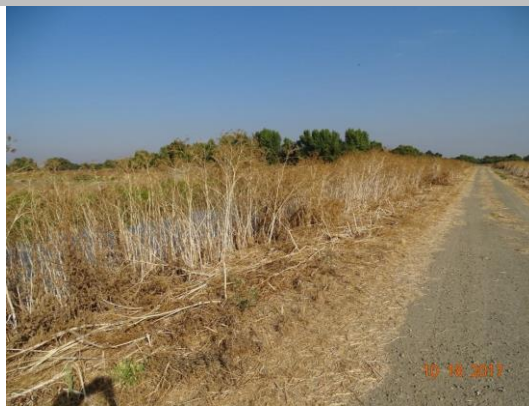
Photo 1 of 2 : SP\_2018\_NA0010\_120\_19\_20180307\_00006.jpg

LM Start	13.64	Rating **	U	Issue No.	19
LM End	13.75	Issue Type +	Ma	Location *	LS
Category	Earthen Levee			GPS Latitude/Longitude	
				Start	End
Item	Vegetation			37.173767 °	37.172157 °
				-120.761018 °	-120.761200 °
DWR ID	DWR_NA0010_02B_s_2017_19				
Comment Code					
V2 : Remove the wild growth other than native grasses from the levee slopes.					
Inspector Comment

Looking north at landside slope.

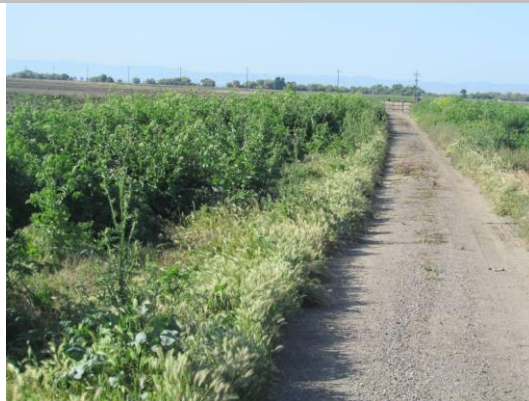
Photo 2 of 2 : SP\_2018\_NA0010\_120\_19\_20180307\_00007.jpg

Looking northwest at dense veg on landward slope.

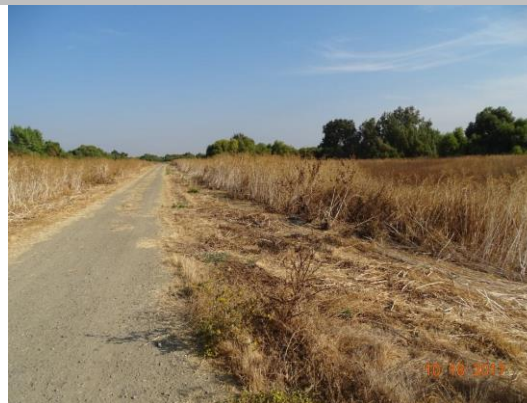
Photo 1 of 1 : SP\_2018\_NA0010\_120\_20\_20180307\_00008.jpg

LM Start	13.64	Rating **	U	Issue No.	20
LM End	13.75	Issue Type +	Ma	Location *	WS
Category	Earthen Levee			GPS Latitude/Longitude	
				Start	End
Item	Vegetation			37.173767 °	37.172157 °
				-120.761018 °	-120.761200 °
DWR ID	DWR_NA0010_02B_s_2017_20				
Comment Code					
V2 : Remove the wild growth other than native grasses from the levee slopes.					
Inspector Comment

Looking north at waterside slope.

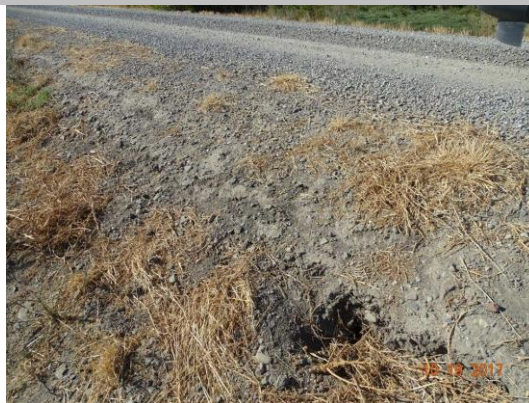
Photo 1 of 1 : SP\_2018\_NA0010\_121\_67\_20180307\_00004.jpg

LM Start	0.19	Rating **	M	Issue No.	67
LM End	0.19	Issue Type +	Ma	Location *	LS
Category	Earthen Levee			GPS Latitude/Longitude	
				Start	End
Item	Animal Control			37.109013 °	37.109013 °
				-120.587799 °	-120.587799 °
DWR ID	DWR_NA0010_03_s _ 2015_67				
Comment Code					
A3 : No rodents visible, but rodent burrows visible; need to backfill and compact or grout burrows.					
Inspector Comment					
Rodent holes noted at landside slope.

Looking southwest at the landside shoulder.

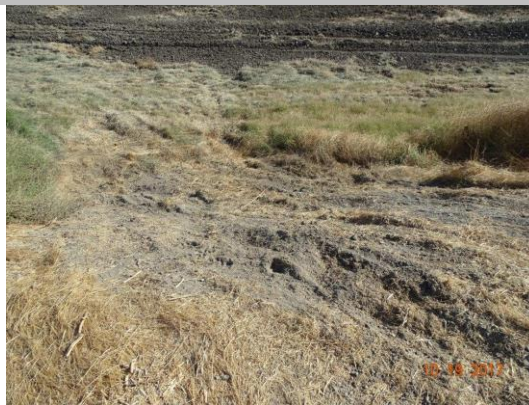
Photo 1 of 1 : SP\_2018\_NA0010\_121\_6\_20180307\_00002.jpg

LM Start	0.43	Rating **	M	Issue No.	6
LM End	0.43	Issue Type +	Ma	Location *	LS
Category	Earthen Levee			GPS Latitude/Longitude	
				Start	End
Item	Slope Stability			37.106121 °	37.106121 °
				-120.585680 °	-120.585680 °
DWR ID	DWR_NA0010_03_f_2017_6				
Comment Code					
S3 : Repair the levee slope damaged by vehicle traffic and prevent access where possible.					
Inspector Comment

Looking east at the landside slope.

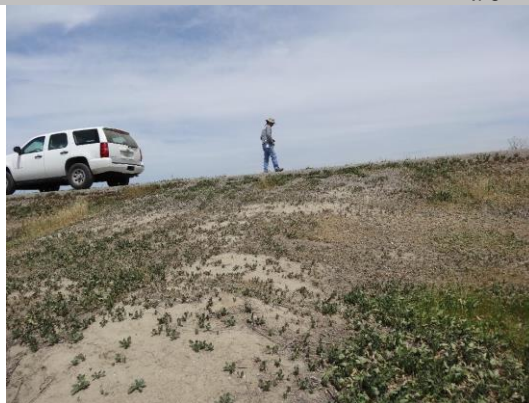
Photo 1 of 3 : UCIP\_SP\_2018\_36534\_66248.jpg

LM Start	0.76	Rating **	A/W	Issue No.	69	
LM End	0.76	Issue Type +	Ma	Location *		
Category	Supplemental			GPS Latitude/Longitude		
				Start	End	
Item	DWR UCIP LMA Responsibility			37.102964 °	37.102964 °	
				-120.581421 °	-120.581421 °	
DWR ID						
Comment Code						
Inspector Comment						
FS_ID:36534						
DS_ID:19692						
EP_NO: N/A						
Repair Type: No Action Needed						
Crossing Status: Found						
UCIP Comments:						
FIELD_STRUCT_DESC: 24-inch corrugated metal gravity drainage pipe						
through the levee, 9.3 feet below the crown. Flap gate on the waterside						
(WS) end. [Additional Reference(s): DWR Levee Log, 2002. USACE						
San Joaquin O&M Manual 601.1, 1967, (HLM 0.77)].						
FS Date: 4/17/2014

View of waterward slope.

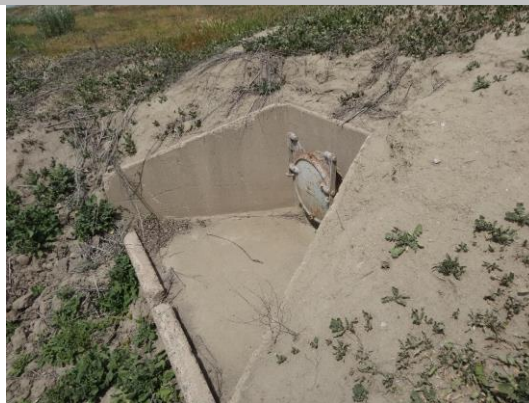
Photo 2 of 3 : UCIP\_SP\_2018\_36534\_66249.jpg

Concrete structure located on waterward side.

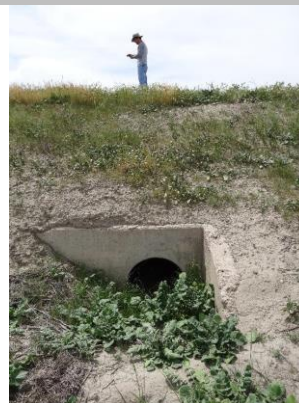
Photo 3 of 3 : UCIP\_SP\_2018\_36534\_66251.jpg

View of landward slope.

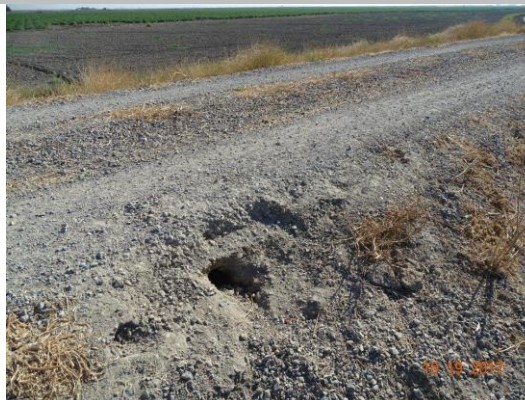
Photo 1 of 1 : SP\_2018\_NA0010\_121\_7\_20180307\_00003.jpg

LM Start	0.83	Rating **	M	Issue No.	7
LM End	0.83	Issue Type +	Ma	Location *	CR
Category	Earthen Levee			GPS Latitude/Longitude	
				Start	End
Item	Animal Control			37.102190 °	37.102190 °
				-120.580717 °	-120.580717 °
DWR ID	DWR_NA0010_03_f_2017_7				
Comment Code					
A1 : Exterminate rodents and backfill and compact or grout burrows.					
Inspector Comment

Looking southeast at the waterside shoulder.

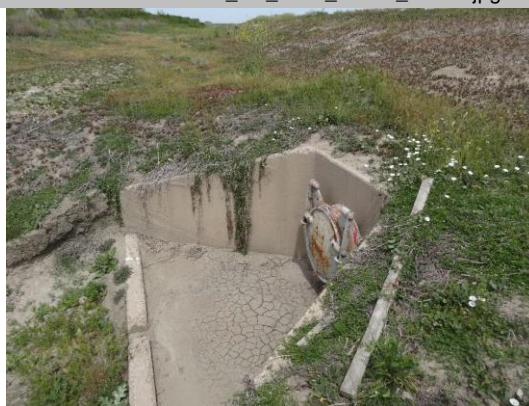
Photo 2 of 3 : UCIP\_SP\_2018\_39371\_66254.jpg

Concrete structure located on waterward side.

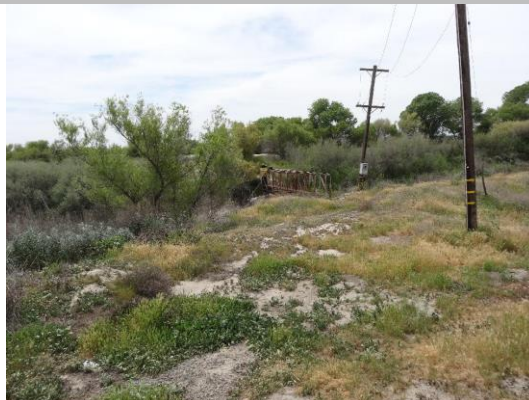
Photo 2 of 3 : UCIP\_SP\_2018\_36543\_66282.jpg

View of walkway and berm on waterward side.

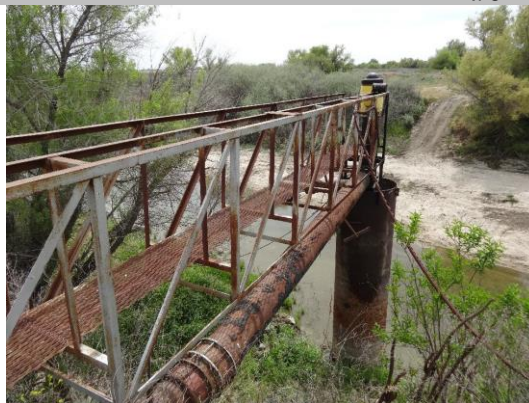
Photo 3 of 3 : UCIP\_SP\_2018\_36543\_66280.jpg

Comment Code						
Inspector Comment						
FS_ID:36543 DS_ID:19694 EP_NO: N/A Repair Type: Non-Urgent Crossing Status: Found UCIP Comments: Need to contact owner--additional appurtenances found on waterward side not part of original description. Unable to determine if walkway, pump, and pipe through waterward berm is if part of original crossing. FIELD_STRUCT_DESC: 36-inch corrugated metal irrigation discharge pipe through the levee, 6.6 feet below the crown. Pump on the riverbank. Slide gate on the waterside (WS) end. [Additional Reference(s): DWR Levee Log, 2002. USACE San Joaquin O&M Manual 601.1, 1967, (HLM 2.05)]. FS Date: 4/17/2014

Pump and damage walkway located on waterward side.

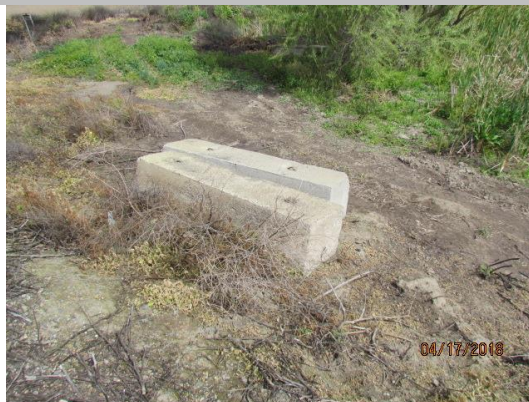
Photo 1 of 1 : SP\_2018\_NA0010\_121\_5\_20180420\_00017.jpg

LM Start	2.05	Rating **	U	Issue No.	5
LM End	2.05	Issue Type +	En	Location *	LS
Category	Earthen Levee			GPS Latitude/Longitude	
				Start	End
Item	Encroachments			37.089289 °	37.089289 °
				-120.567463 °	-120.567463 °
DWR ID	DWR_NA0010_03_s_2018_5				
Comment Code					
MA : Material					
Inspector Comment					
Two large concrete blocks on landward toe.

Looking southwest at concrete blocks on landward toe. (Spring 2018)

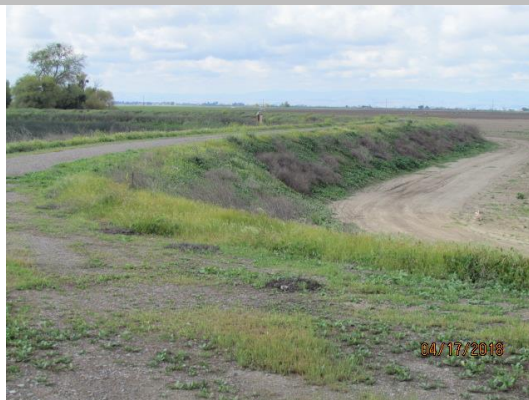
Photo 1 of 1 : SP\_2018\_NA0010\_122\_9\_20180420\_00023.jpg

LM Start	0.00	Rating **	M	Issue No.	9
LM End	1.40	Issue Type +	Ma	Location *	LS
Category	Earthen Levee			GPS Latitude/Longitude	
				Start	End
Item	Vegetation			37.112601 °	°
				-120.589042 °	°
DWR ID	DWR_NA0010_04_s_2018_9				
Comment Code					
V1 : Control annual grass and weeds on the levee slopes and easements.					
Inspector Comment

Looking north at typical view of landward slope. (Spring 2018)

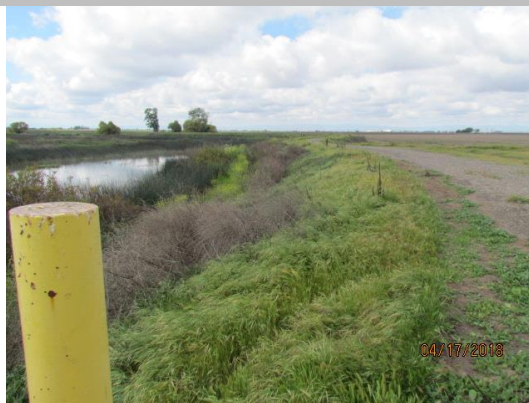
Photo 1 of 1 : SP\_2018\_NA0010\_122\_10\_20180420\_00024.jpg

LM Start	0.00	Rating **	M	Issue No.	10
LM End	1.41	Issue Type +	Ma	Location *	WS
Category	Earthen Levee			GPS Latitude/Longitude	
				Start	End
Item	Vegetation			37.112601 °	°
				-120.589042 °	°
DWR ID	DWR_NA0010_04_s_2018_10				
Comment Code					
V1 : Control annual grass and weeds on the levee slopes and easements.					
Inspector Comment

Looking north at typical view of waterward slope. (Spring 2018)

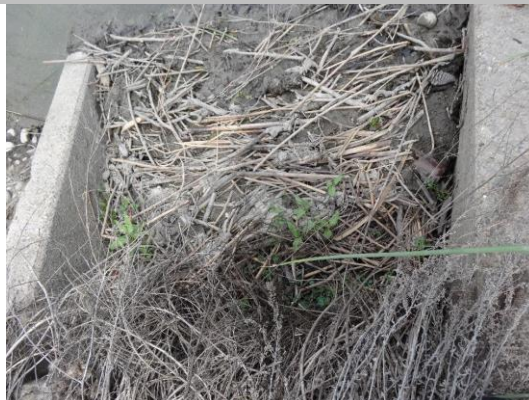
Photo 2 of 3 : UCIP\_SP\_2018\_34093\_61981.jpg

Sediment blocking flap gate located on waterward side.

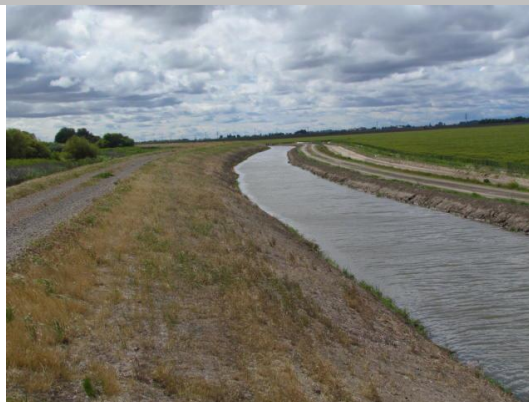
Photo 1 of 3 : SP\_2018\_NA0010\_122\_3\_20180307\_00001.jpg

LM Start	0.32	Rating **	M	Issue No.	3
LM End	1.41	Issue Type +	En	Location *	LS
Category	Earthen Levee			GPS Latitude/Longitude	
				Start	End
Item	Encroachments			37.108822 °	37.097556 °
				-120.590718 °	-120.578130 °
DWR ID	DWR_NA0010_04_s_2012_3				
Comment Code					
DT : Ditch					
Inspector Comment					
Agricultural ditch within 10' easement.

Looking north at irrigation ditch at landside toe.

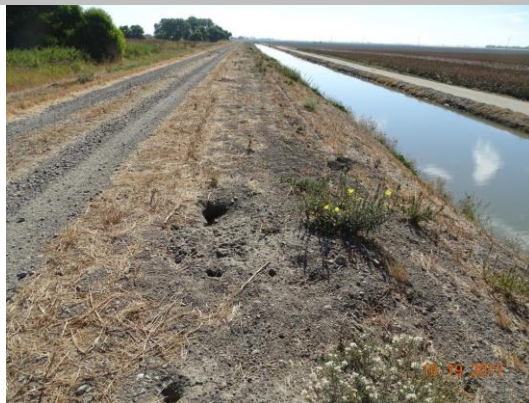
Photo 1 of 1 : SP\_2018\_NA0010\_122\_8\_20180307\_00004.jpg

LM Start	0.55	Rating **	M	Issue No.	8
LM End	0.55	Issue Type +	Ma	Location *	LS
Category	Earthen Levee			GPS Latitude/Longitude	
				Start	End
Item	Animal Control			37.105957 °	37.105957 °
				-120.588684 °	-120.588684 °
DWR ID	DWR_NA0010_04_f_2017_8				
Comment Code					
A3 : No rodents visible, but rodent burrows visible; need to backfill and compact or grout burrows.					
Inspector Comment

Looking south at landside slope.

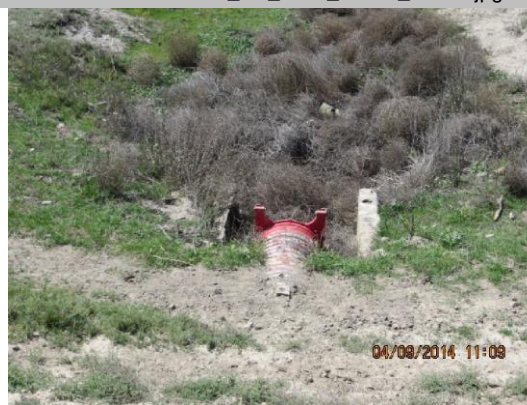
Photo 1 of 3 : UCIP\_SP\_2018\_39563\_60921.jpg

LM Start	0.08	Rating **	M	Issue No.	1311	
LM End	0.08	Issue Type +	Ma	Location *		
Category	Supplemental			GPS Latitude/Longitude		
				Start		End
Item	DWR UCIP LMA Responsibility			37.278174 °		37.278174 °
				-120.823465 °		-120.823465 °
DWR ID						
Comment Code						
Inspector Comment						
FS_ID:39563 DS_ID:19756 EP_NO: N/A Repair Type: Non-Urgent Crossing Status: Found UCIP Comments: Debris blocking landward headwall--recommend clearing. FIELD_STRUCT_DESC: 24-inch corrugated metal gravity drainage pipe through the levee, 8.6 feet below the crown. Concrete U-shaped headwall and flap gate on the waterside (WS) end. Concrete headwall on the landside (LS) end. [Additional Reference(s): DWR Levee Log, 2002. USACE San Joaquin O&M Manual 601.1, 1967, (HLM 0.07)]. FS Date: 4/9/2014

Pipe, flapgate, and concrete headwall on WS toe.

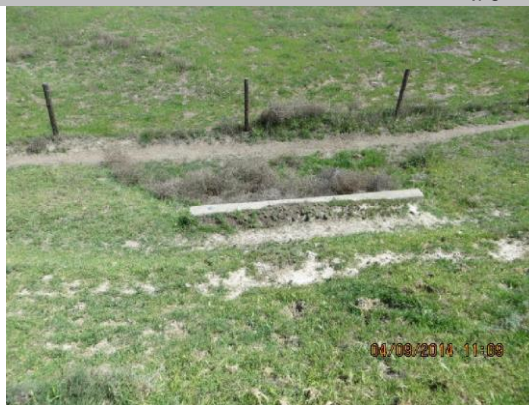
Photo 3 of 3 : UCIP\_SP\_2018\_39563\_60922.jpg

Pipe and concrete headwall on LS toe.

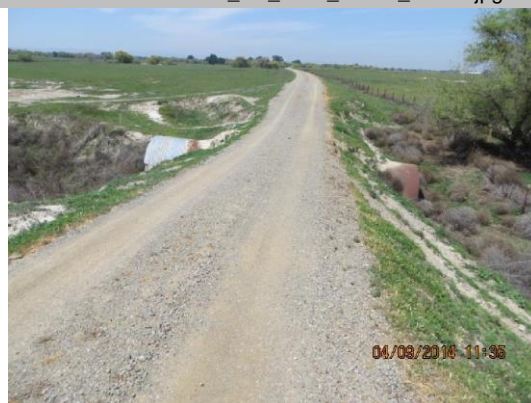
Photo 1 of 3 : UCIP\_SP\_2018\_49967\_71469.jpg

Comment Code					
Inspector Comment					
FS_ID:49967 DS_ID:24867 EP_NO: N/A Repair Type: Urgent Crossing Status: Found UCIP Comments: 07/20/2016 same as previous inspection. Levee section at crossing has been degraded. According to LMA representative, Rick, the low point at crossing has been present for over 10 years when the pipe was replaced. (DWR UCIP - omagana)04/09/2014 Pipe is open on both ends and levee has been degraded at this location. No permit identified for this crossing. (DWR UCIP - omagana) FIELD_STRUCT_DESC: 96-inch corrugated metal gravity drainage pipe through the levee, 4.5 feet below the crown. Pipe is composed of two materials: corrugated metal pipe (CMP) on the waterside (WS) and steel pipe on the landside (LS). This section of the levee is a degraded section that drops approximately 4 feet within 100 feet of length. This section of the levee is the site of the 1960s levee breach. [Additional Reference(s): USACE Periodic Inspection Report 2014, USACE_CESPK_L05A_2014_p_0014]. FS Date: 7/20/2016

Pipe through levee where levee has been degraded.

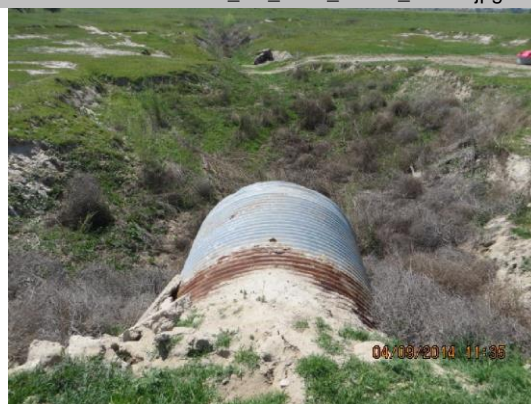
Photo 2 of 3 : UCIP\_SP\_2018\_49967\_71467.jpg

Pipe on WS toe.
