**Flood Control Project Maintenance  
Levee Inspections**  
**LMA District Cover Sheet**  
**Spring 2018 Levee Inspection Results**

**Lower San Joaquin Levee District**

**Spring 2018 Levee Inspection Results**

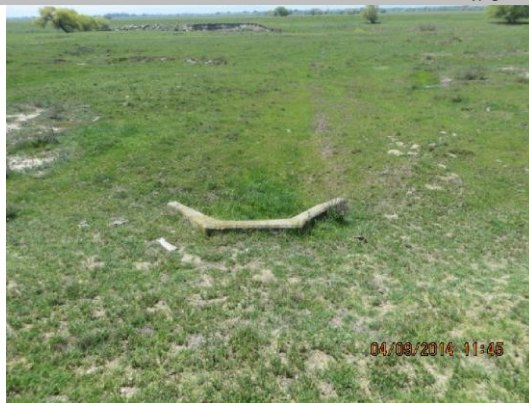
Photo 1 of 3 : UCIP\_SP\_2018\_39584\_60926.jpg

LM Start	0.60	Rating **	M	Issue No.	1313	
LM End	0.60	Issue Type +	Ma	Location *		
Category	Supplemental			GPS Latitude/Longitude		
				Start	End	
Item	DWR UCIP LMA Responsibility			37.273945 °	37.273945 °	
				-120.815835 °	-120.815835 °	
DWR ID						
Comment Code						
Inspector Comment						
FS_ID:39584 DS_ID:19757 EP_NO: N/A Repair Type: Non-Urgent Crossing Status: Found UCIP Comments: Excess debris on landward headwall--recommend clearing. FIELD_STRUCT_DESC: 30-inch corrugated metal gravity drainage pipe through the levee, 7.5 feet below the crown. Flap gate on the waterside (WS) end. Concrete headwall on the landside (LS) end. Concrete U-shaped headwall on the WS end. [Additional Reference(s): DWR Levee Log, 2002. USACE San Joaquin O&M Manual 601.1, 1967, (HLM 0.59)]. FS Date: 4/9/2014

Concrete headwall, pipe, and flapgate on WS toe.

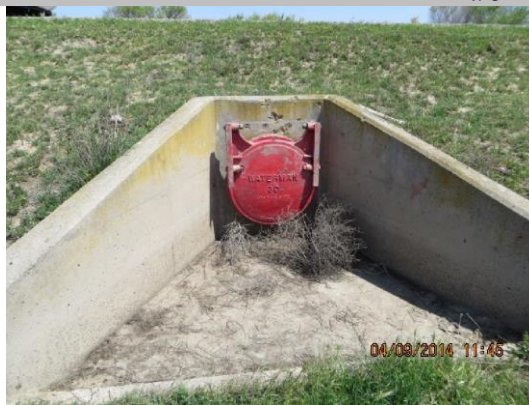
Photo 2 of 3 : UCIP\_SP\_2018\_39584\_60925.jpg

Concrete headwall, pipe, and flapgate on WS toe.

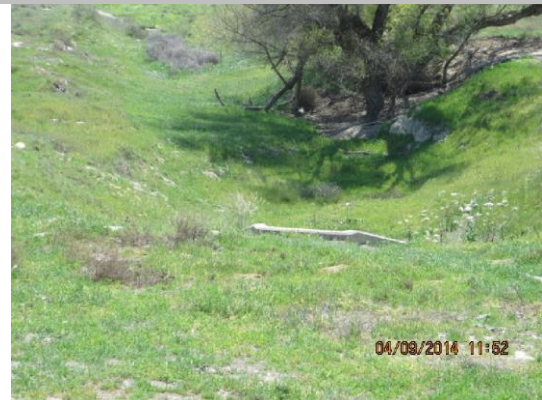
Photo 1 of 3 : UCIP\_SP\_2018\_39585\_60931.jpg

Comment Code					
Inspector Comment					
FS_ID:39585 DS_ID:19758 EP_NO: N/A Repair Type: Non-Urgent Crossing Status: Found UCIP Comments: Dense vegetation limits the inspector's visibility to identify signs of pipe failure (leaks) along the landward slope. Recommend removing vegetation along pipe alignment to conduct proper inspection of structure. FIELD_STRUCT_DESC: 36-inch corrugated metal gravity drainage pipe through the levee, 13.2 feet below the crown. Flap gate on the waterside (WS) end. Concrete headwall on the landside (LS) end. Concrete U-shaped headwall on the WS end. Cobble revetment around both ends. [Additional Reference(s): DWR Levee Log, 2002. USACE San Joaquin O&M Manual 601.1, 1967, (HLM 0.65)]. FS Date: 4/9/2014

Concrete headwall visible off WS toe.

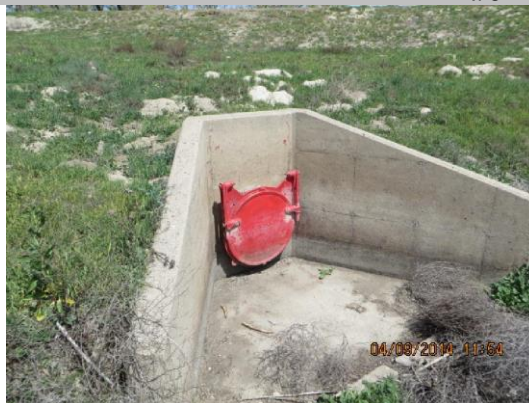
Photo 2 of 3 : UCIP\_SP\_2018\_39585\_60929.jpg

Comment Code					
Inspector Comment					
FS_ID:39585 DS_ID:19758 EP_NO: N/A Repair Type: Non-Urgent Crossing Status: Found UCIP Comments: Dense vegetation limits the inspector's visibility to identify signs of pipe failure (leaks) along the landward slope. Recommend removing vegetation along pipe alignment to conduct proper inspection of structure. FIELD_STRUCT_DESC: 36-inch corrugated metal gravity drainage pipe through the levee, 13.2 feet below the crown. Flap gate on the waterside (WS) end. Concrete headwall on the landside (LS) end. Concrete U-shaped headwall on the WS end. Cobble revetment around both ends. [Additional Reference(s): DWR Levee Log, 2002. USACE San Joaquin O&M Manual 601.1, 1967, (HLM 0.65)]. FS Date: 4/9/2014

Pipe, flapgate, and headwall at WS toe.

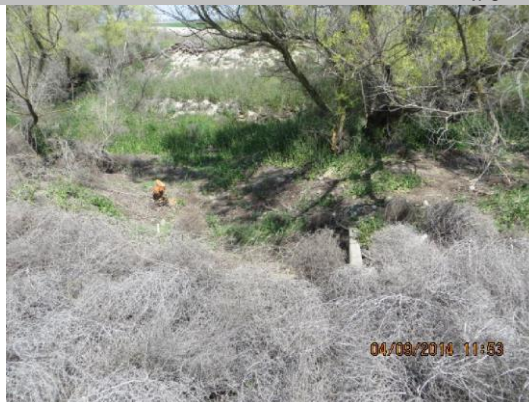
Photo 3 of 3 : UCIP\_SP\_2018\_39585\_60930.jpg

Concrete headwall at LS toe.

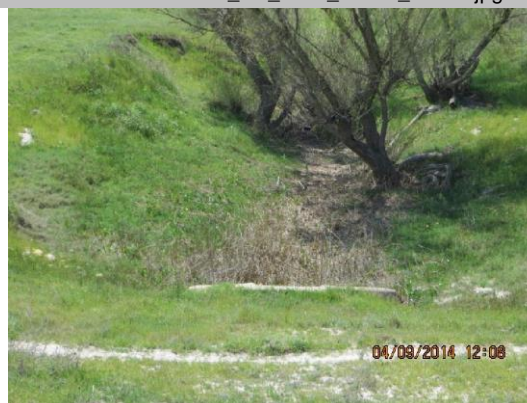
Photo 1 of 3 : UCIP\_SP\_2018\_33707\_60934.jpg

LM Start	0.85	Rating **	A/W	Issue No.	1315
LM End	0.85	Issue Type +	Ma	Location *	
Category	Supplemental			GPS Latitude/Longitude	
				Start	End
Item	DWR UCIP LMA Responsibility			37.271894 °	37.271894 °
				-120.812224 °	-120.812224 °
DWR ID					
Comment Code					
Inspector Comment					
FS_ID:33707 DS_ID:19759 EP_NO: N/A Repair Type: No Action Needed Crossing Status: Found UCIP Comments: FIELD_STRUCT_DESC: 24-inch corrugated metal gravity drainage pipe through the levee, 14.4 feet below the crown. Flap gate on the waterside (WS) end. Concrete headwall on the landside (LS) end. Concrete U-shaped headwall on the WS end. [Additional Reference(s): DWR Levee Log, 2002. USACE San Joaquin O&M Manual 601.1, 1967, (HLM 0.84)]. FS Date: 4/9/2014

Concrete headwall visible at LS toe.

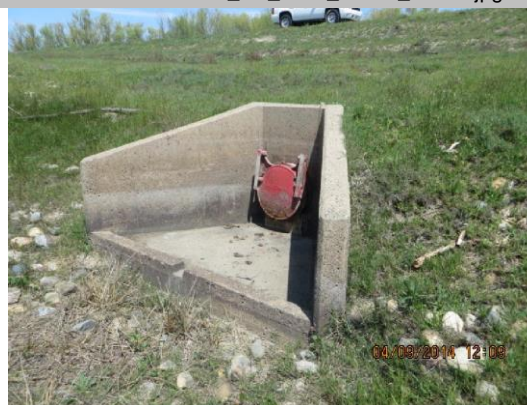
Photo 2 of 3 : UCIP\_SP\_2018\_33707\_60933.jpg

Pipe, flapgate, and headwall at WS toe.

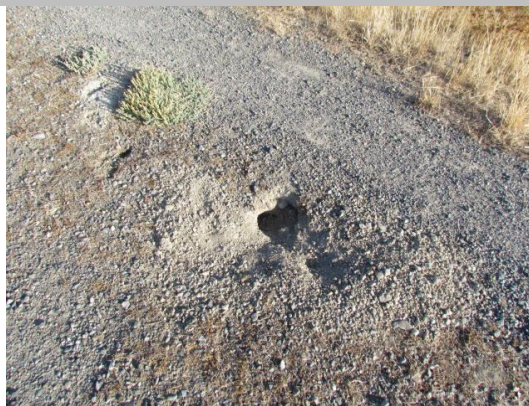
Photo 1 of 1 : SP\_2018\_NA0010\_123\_80\_20180307\_00014.jpg

LM Start	1.66	Rating **	M	Issue No.	80
LM End	1.75	Issue Type +	Ma	Location *	LS
Category	Earthen Levee			GPS Latitude/Longitude	
				Start	End
Item	Animal Control			37.263448 °	37.262225 °
				-120.802715 °	-120.802296 °
DWR ID	DWR_NA0010_05_f_2015_80				
Comment Code					
A3 : No rodents visible, but rodent burrows visible; need to backfill and compact or grout burrows.					
Inspector Comment					
Several rodent holes on levee crown within this section.

Looking at typical view of rodent holes within this section on landward slope.

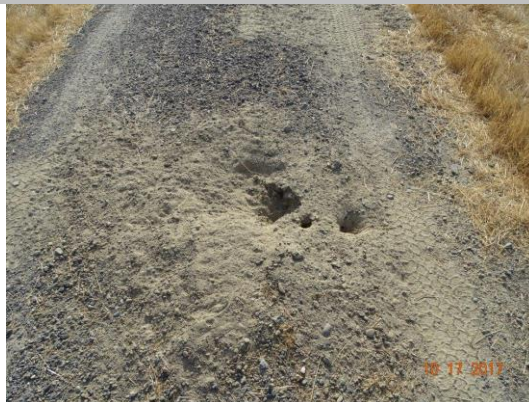
Photo 1 of 1 : SP\_2018\_NA0010\_123\_113\_20180307\_00022.jpg

LM Start	2.39	Rating **	A/W	Issue No.	113
LM End	2.40	Issue Type +	Ma	Location *	CR
Category	Earthen Levee			GPS Latitude/Longitude	
				Start	End
Item	Animal Control			37.257060 °	37.256981 °
				-120.792823 °	-120.792707 °
DWR ID	DWR_NA0010_05_f_2017_113				
Comment Code					
A3 : No rodents visible, but rodent burrows visible; need to backfill and compact or grout burrows.					
Inspector Comment					
LMA graded levee crown and backfilled rodent holes. Need to monitor site.

Looking at rodent holes on the levee crown.

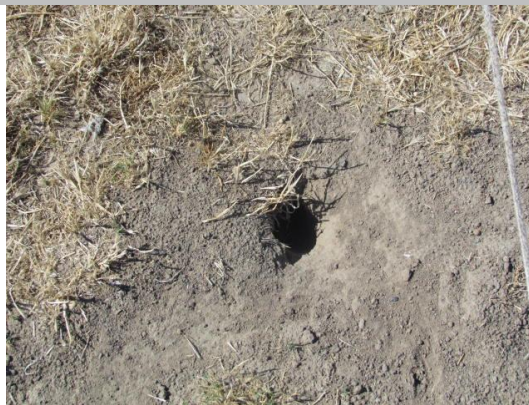
Photo 1 of 1 : SP\_2018\_NA0010\_123\_6\_20180307\_00006.jpg

LM Start	3.20	Rating **	A/W	Issue No.	6
LM End	3.35	Issue Type +	Ma	Location *	WS
Category	Earthen Levee			GPS Latitude/Longitude	
				Start	End
Item	Animal Control			37.256635 °	37.255170 °
				-120.778935 °	-120.776882 °
DWR ID	DWR_NA0010_05_s_2014_6				
Comment Code					
A1 : Exterminate rodents and backfill and compact or grout burrows.					
Inspector Comment					
No rodent visible but several rodent holes visible on levee crown. LMA graded levee crown and backfilled rodent holes.

Looking at typical view of rodent holes on waterward slope.

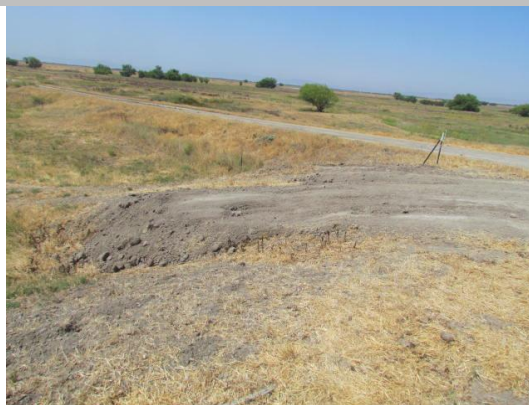
Photo 2 of 3 : SP\_2018\_NA0010\_123\_7\_20180307\_00008.jpg

LM Start	<b>3.20</b>	Rating **	M	Issue No.	<b>7 (cont)</b>
LM End	<b>3.20</b>	Issue Type +	En	Location *	WS

Looking northwest at unauthorized ramp on waterward slope.

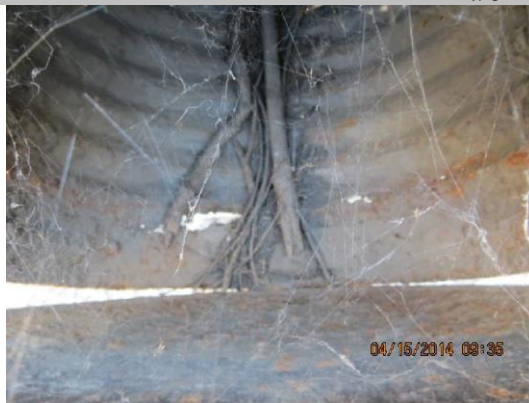
Photo 3 of 3 : UCIP\_SP\_2018\_43055\_60951.jpg

LM Start	3.34	Rating **	M	Issue No.	1318 (cont)	
LM End	3.34	Issue Type +	Ma	Location *		
Category	Supplemental			GPS Latitude/Longitude		
				Start	End	
Item	DWR UCIP LMA Responsibility			37.255258 °	37.255258 °	
				-120.776996 °	-120.776996 °	
DWR ID						
Comment Code						
Inspector Comment						
FS_ID:43055						
DS_ID:19810						
EP_NO: N/A						
Repair Type: Non-Urgent						
Crossing Status: Found						
UCIP Comments: Pipe corroded through at flapgate on WS toe.						
FIELD_STRUCT_DESC: 24-inch corrugated metal gravity drainage pipe						
through the levee, 14.7 feet below the crown. Flap gate on the						
waterside (WS) end. Concrete U-shaped headwall on each end.						
[Additional Reference(s): DWR Levee Log, 2002. USACE San Joaquin						
O&M Manual 601.1, 1967, (HLM 3.33)].						
FS Date: 4/15/2014

Pipe corroded through just behind flapgate at WS toe.

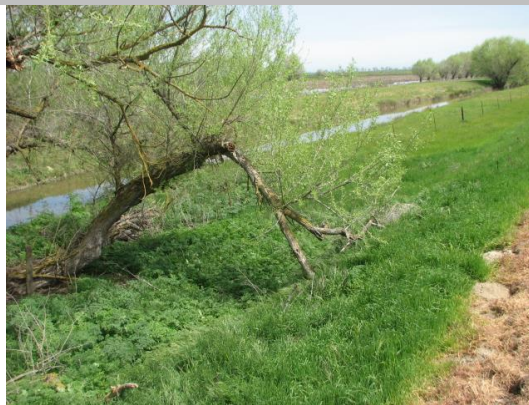
Photo 1 of 2 : SP\_2018\_NA0010\_123\_114\_20180411\_00307.jpg

LM Start	3.54	Rating **	M	Issue No.	114
LM End	3.54	Issue Type +	Ma	Location *	LS
Category	Earthen Levee			GPS Latitude/Longitude	
				Start	End
Item	Encroachments			37.255191 °	37.255191 °
				-120.773667 °	-120.773667 °
DWR ID	DWR_NA0010_05_f_2017_114				
Comment Code					
TR : Tree or limb					
Inspector Comment					
Broken tree branch on landward slope and toe.

Looking upstream at broken tree limb on landward slope. (Spring 2018)

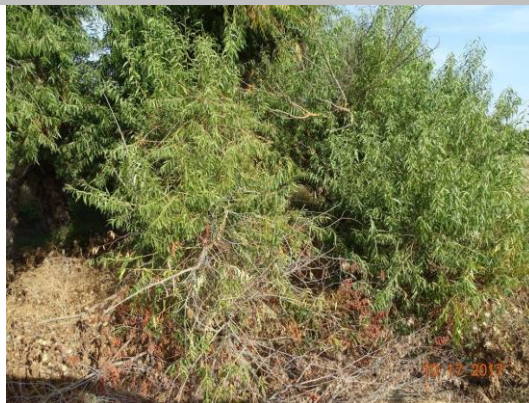
Photo 2 of 2 : SP\_2018\_NA0010\_123\_114\_20180307\_00023.jpg

LM Start	3.54	Rating **	M	Issue No.	114 (cont)	
LM End	3.54	Issue Type +	Ma	Location *	LS	
Category	Earthen Levee			GPS Latitude/Longitude		
				Start		End
Item	Encroachments			37.255191 °		37.255191 °
				-120.773667 °		-120.773667 °
DWR ID	DWR_NA0010_05_f_2017_114					
Comment Code						
TR : Tree or limb						
Inspector Comment						
Broken tree branch on landward slope and toe.

Looking northwest at the landside slope.

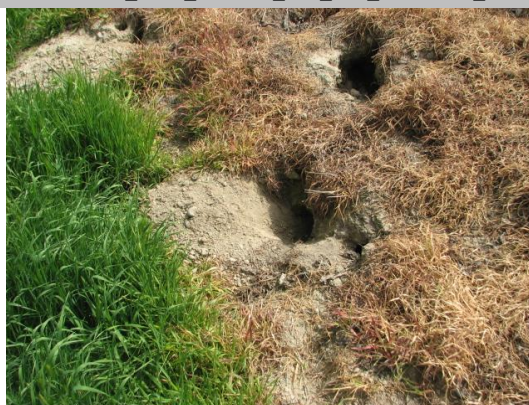
Photo 1 of 1 : SP\_2018\_NA0010\_123\_134\_20180411\_00308.jpg

LM Start	3.55	Rating **	U	Issue No.	134
LM End	3.55	Issue Type +	Ma	Location *	LS
Category	Earthen Levee			GPS Latitude/Longitude	
				Start	End
Item	Animal Control			37.255202 °	37.255202 °
				-120.773655 °	-120.773655 °
DWR ID	DWR_NA0010_05_s_2018_134				
Comment Code					
Inspector Comment					
Several rodent holes within this section.

Looking at typical rodent holes within this section. (Spring 2018)

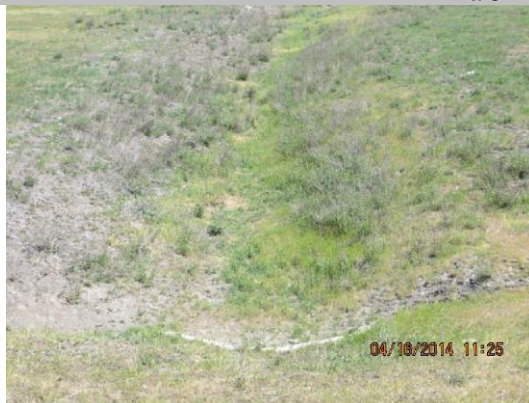
Photo 1 of 3 : UCIP\_SP\_2018\_39586\_61137.jpg

LM Start	3.68	Rating **	M	Issue No.	1319
LM End	3.68	Issue Type +	Ma	Location *	
Category	Supplemental			GPS Latitude/Longitude	
				Start	End
Item	DWR UCIP LMA Responsibility			37.252308 °	37.252308 °
				-120.768038 °	-120.768038 °
DWR ID					
Comment Code					
Inspector Comment					
FS_ID:39586 DS_ID:19811 EP_NO: N/A Repair Type: Non-Urgent Crossing Status: Found UCIP Comments: Sediment buildup in pipe visible from landward side--recommend contacting owner to clear pipe. FIELD_STRUCT_DESC: 24-inch corrugated metal gravity drainage pipe through the levee, 15 feet below the crown. Flap gate on the waterside (WS) end. Concrete headwall on the landside (LS) end. Concrete U-shaped headwall on the WS end. [Additional Reference(s): DWR Levee Log, 2002. USACE San Joaquin O&M Manual 601.1, 1967, (HLM 3.67)]. FS Date: 4/16/2014

Pipe, headwall, and flapgate on WS toe.

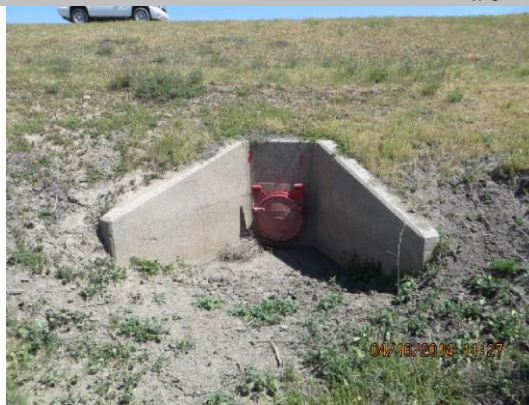
Photo 2 of 3 : UCIP\_SP\_2018\_39586\_61138.jpg

LM Start	<b>3.68</b>	Rating **	M	Issue No.	<b>1319 (cont)</b>
LM End	<b>3.68</b>	Issue Type +	Ma	Location *

Pipe, headwall, and flapgate on WS toe.

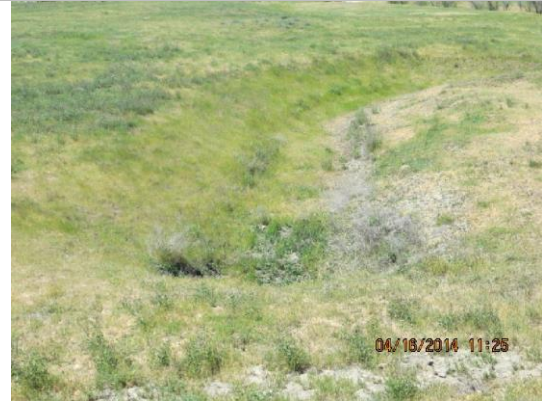
Photo 3 of 3 : UCIP\_SP\_2018\_39586\_61136.jpg

LM Start	3.68	Rating **	M	Issue No.	1319 (cont)
LM End	3.68	Issue Type +	Ma	Location *	
Category	Supplemental			GPS Latitude/Longitude	
				Start	End
Item	DWR UCIP LMA Responsibility			37.252308 °	37.252308 °
				-120.768038 °	-120.768038 °
DWR ID					
Comment Code					
Inspector Comment					
FS_ID:39586 DS_ID:19811 EP_NO: N/A Repair Type: Non-Urgent Crossing Status: Found UCIP Comments: Sediment buildup in pipe visible from landward side--recommend contacting owner to clear pipe. FIELD_STRUCT_DESC: 24-inch corrugated metal gravity drainage pipe through the levee, 15 feet below the crown. Flap gate on the waterside (WS) end. Concrete headwall on the landside (LS) end. Concrete U-shaped headwall on the WS end. [Additional Reference(s): DWR Levee Log, 2002. USACE San Joaquin O&M Manual 601.1, 1967, (HLM 3.67)]. FS Date: 4/16/2014

Pipe and headwall on LS toe.

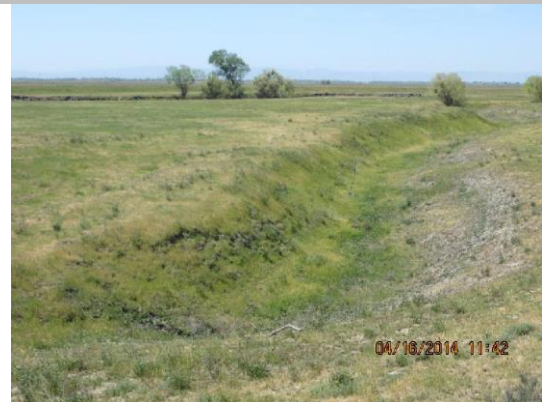
Photo 1 of 3 : UCIP\_SP\_2018\_39880\_61142.jpg

LM Start	4.02	Rating **	M	Issue No.	1320
LM End	4.02	Issue Type +	Ma	Location *	
Category	Supplemental			GPS Latitude/Longitude	
				Start	End
Item	DWR UCIP LMA Responsibility			37.248432 °	37.248432 °
				-120.764066 °	-120.764066 °
DWR ID					
Comment Code					
Inspector Comment					
FS_ID:39880 DS_ID:19769 EP_NO: N/A Repair Type: Non-Urgent Crossing Status: Found UCIP Comments: Sediment buildup in pipe visible from landward side--recommend contacting owner to clear pipe. FIELD_STRUCT_DESC: 24-inch corrugated metal gravity drainage pipe through the levee, 16 feet below the crown. Flap gate on the waterside (WS) end. Concrete U-shaped headwall on each end. [Additional Reference(s): DWR Levee Log, 2002. USACE San Joaquin O&M Manual 601.1, 1967, (HLM 4.02)]. FS Date: 4/16/2014

Pipe, headwall, and flapgate on WS toe.

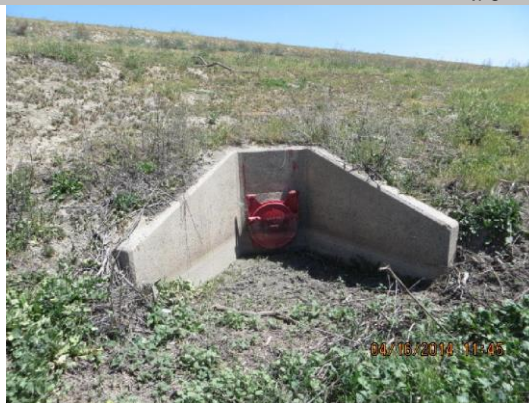
Photo 2 of 3 : UCIP\_SP\_2018\_39880\_61143.jpg

LM Start	<b>4.02</b>	Rating **	M	Issue No.	<b>1320 (cont)</b>
LM End	<b>4.02</b>	Issue Type +	Ma	Location *

Pipe, headwall, and flapgate on WS toe.

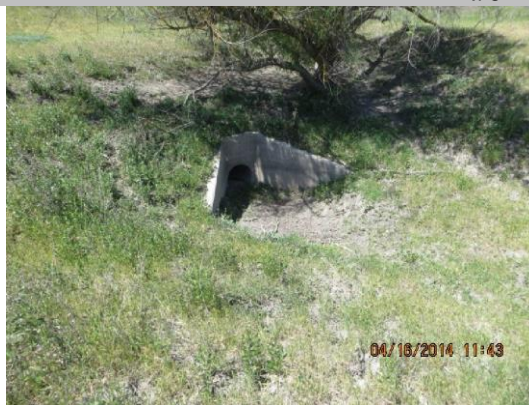
Photo 3 of 3 : UCIP\_SP\_2018\_39880\_61141.jpg

Pipe and headwall on LS toe.

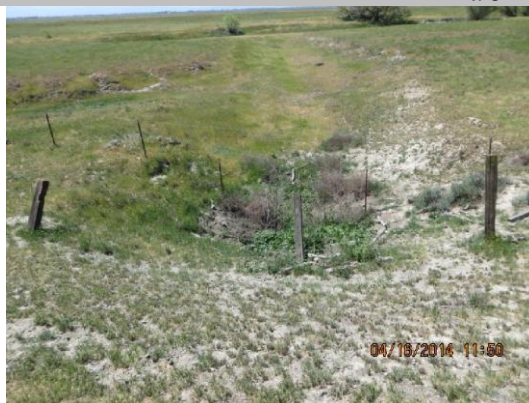
Photo 1 of 3 : UCIP\_SP\_2018\_39588\_61146.jpg

LM Start	4.27	Rating **	M	Issue No.	1321
LM End	4.27	Issue Type +	Ma	Location *	
Category	Supplemental			GPS Latitude/Longitude	
				Start	End
Item	DWR UCIP LMA Responsibility			37.246008 °	37.246008 °
				-120.760706 °	-120.760706 °
DWR ID					
Comment Code					
Inspector Comment					
FS_ID:39588 DS_ID:19770 EP_NO: N/A Repair Type: Non-Urgent Crossing Status: Found UCIP Comments: Sediment buildup in pipe visible from landward side-- recommend contacting owner to clear pipe. FIELD_STRUCT_DESC: 24-inch corrugated metal gravity drainage pipe through the levee, 11.6 feet below the crown. Flap gate on the waterside (WS) end. Concrete headwall on the landside (LS) end. Concrete U-shaped headwall on the WS end. [Additional Reference(s): DWR Levee Log, 2002. USACE San Joaquin O&M Manual 601.1, 1967, (HLM 4.27)]. FS Date: 4/16/2014

Pipe, headwall, and flapgate on WS toe.

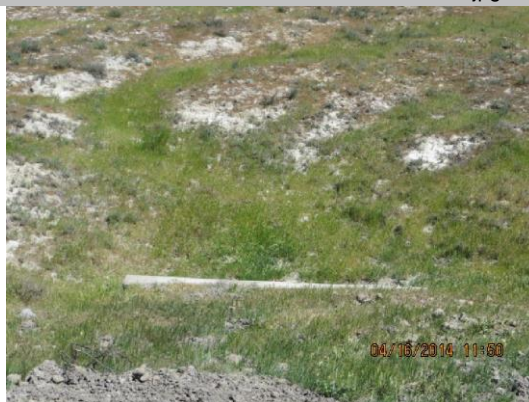
Photo 3 of 3 : UCIP\_SP\_2018\_39588\_61147.jpg

Concrete headwall and pipe on LS toe.

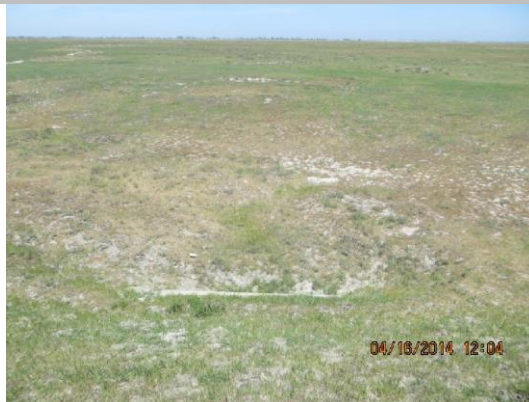
Photo 3 of 3 : UCIP\_SP\_2018\_39590\_62086.jpg

Headwall and pipe on LS toe.

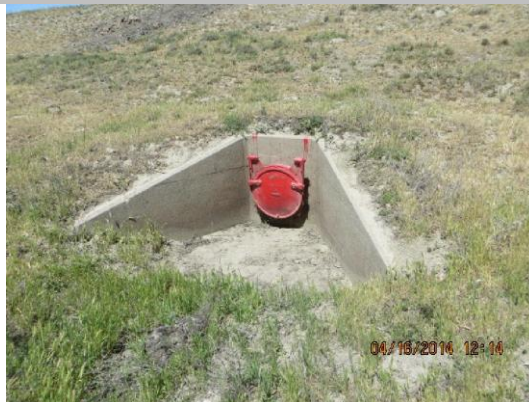
Photo 2 of 3 : UCIP\_SP\_2018\_39591\_62093.jpg

Headwall, flapgate, and pipe on WS toe.

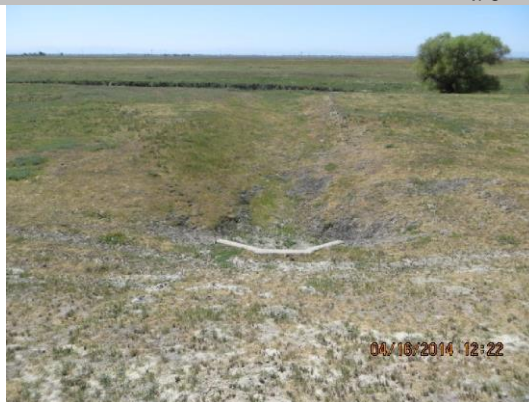
Photo 1 of 3 : UCIP\_SP\_2018\_34151\_62096.jpg

Headwall, flapgate, and pipe on WS toe.

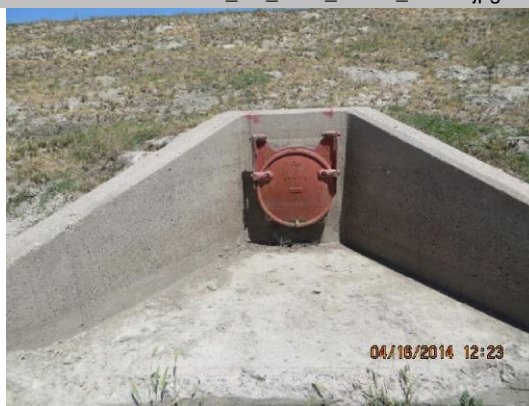
Photo 2 of 3 : UCIP\_SP\_2018\_34151\_62095.jpg

Headwall, flapgate, and pipe on WS toe.

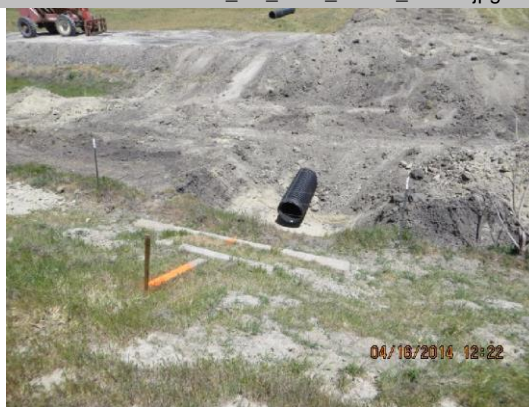
Photo 3 of 3 : UCIP\_SP\_2018\_34151\_62097.jpg

Headwall and pipe on LS toe with HDPE drain pipe being installed off LS toe.

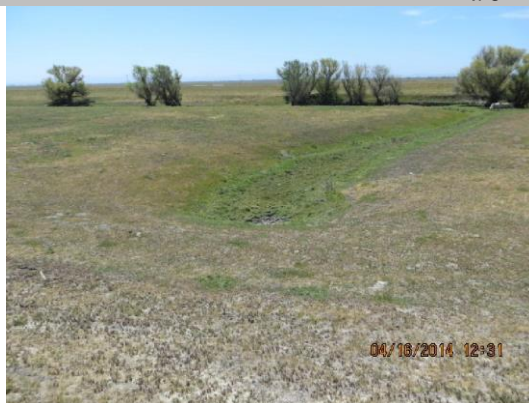
Photo 1 of 3 : UCIP\_SP\_2018\_34163\_62102.jpg

Headwall, flapgate, and pipe on WS toe.

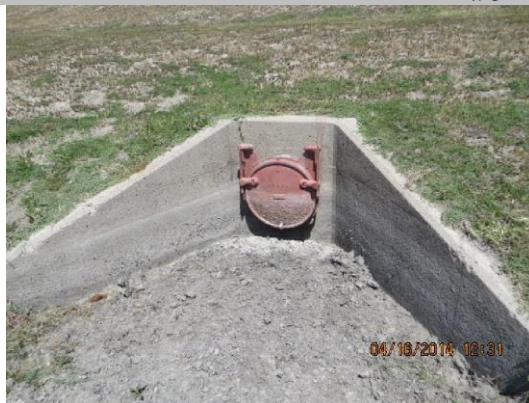
Photo 2 of 3 : UCIP\_SP\_2018\_34163\_62101.jpg

Headwall, flapgate, and pipe on WS toe.

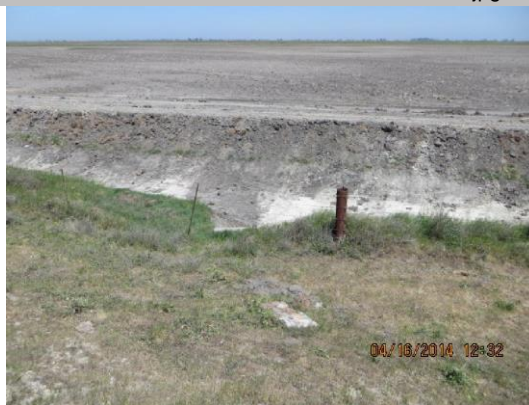
Photo 3 of 3 : UCIP\_SP\_2018\_34163\_62100.jpg

Headwall and pipe on LS toe.

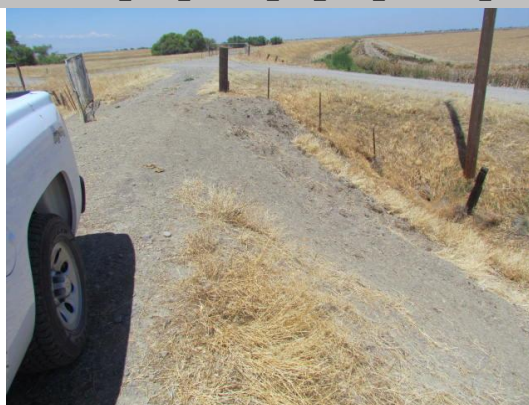
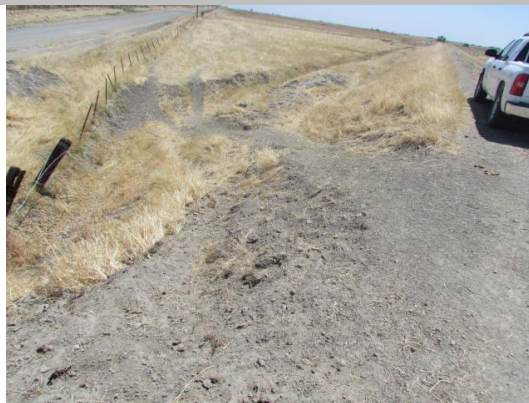
LM Start	6.59	Rating **	M	Issue No.	1309
LM End	6.59	Issue Type +	Ma	Location *	LS
Category	Earthen Levee			GPS Latitude/Longitude	
				Start	End
Item	Slope Stability			37.229682 °	37.229682 °
				-120.726305 °	-120.726305 °
DWR ID	DWR_NA0010_05_s _ 2015_1309				
Comment Code					
S2 : Repair the levee slope damaged by foot traffic and prevent access where possible.					
Inspector Comment					
Landside slope damage caused by animal foot traffic.

Looking north at damaged landward slope.

Looking east at damaged landward slope.

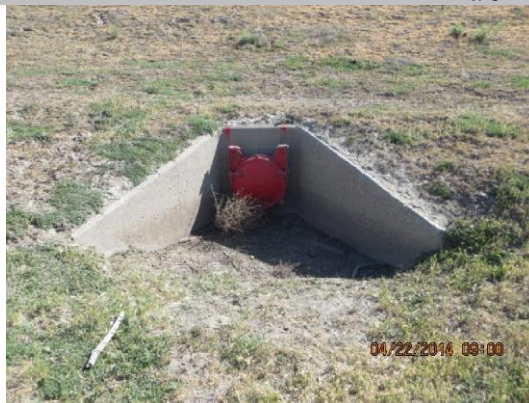
Photo 2 of 3 : UCIP\_SP\_2018\_39592\_62113.jpg

Headwall, flapgate, and pipe on WS toe.

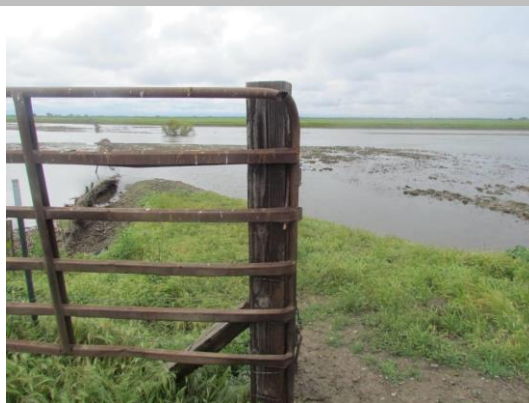
Photo 1 of 1 : SP\_2018\_NA0010\_123\_104\_20180307\_00016.jpg

LM Start	8.09	Rating **	A/W	Issue No.	104
LM End	8.09	Issue Type +	Ma	Location *	CR
Category	Earthen Levee			GPS Latitude/Longitude	
				Start	End
Item	Repair Gates			37.213580 °	37.213580 °
				-120.706550 °	-120.706550 °
DWR ID	DWR_NA0010_05_s _ 2017_104				
Comment Code					
Inspector Comment					
Replace or repair gate not opening correctly bend fence post. Gate was repaired to allow opening.

Looking bend gate near hinge point.

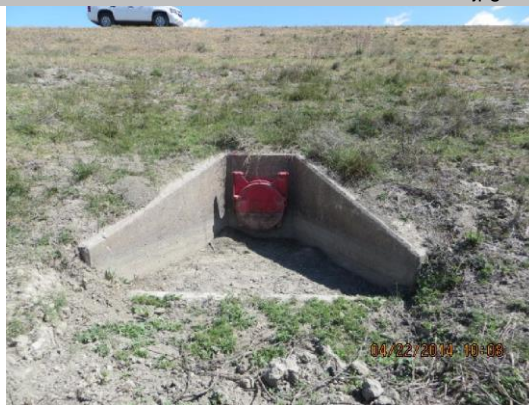
Photo 2 of 3 : UCIP\_SP\_2018\_34265\_62183.jpg

Headwall, flapgate, and pipe on WS toe

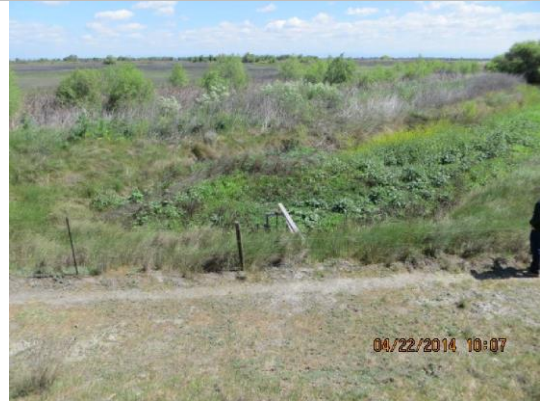
Photo 3 of 3 : UCIP\_SP\_2018\_34265\_62181.jpg

Headwall, slidegate, and pipe on LS toe.

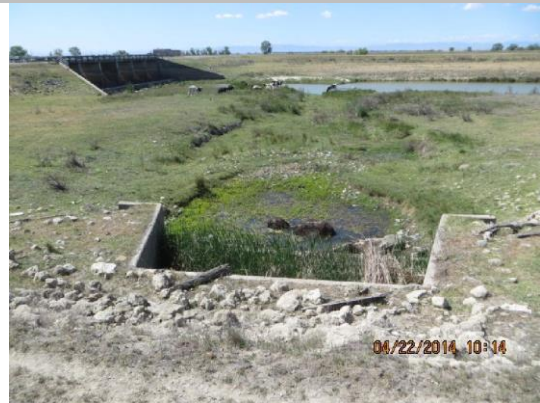
Photo 1 of 3 : UCIP\_SP\_2018\_34267\_62186.jpg

Concrete headwall at outlet on WS toe.

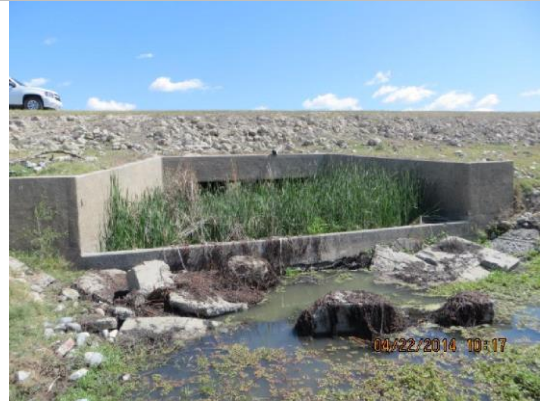
Photo 2 of 3 : UCIP\_SP\_2018\_34267\_62187.jpg

Concrete headwall at outlet on WS toe.

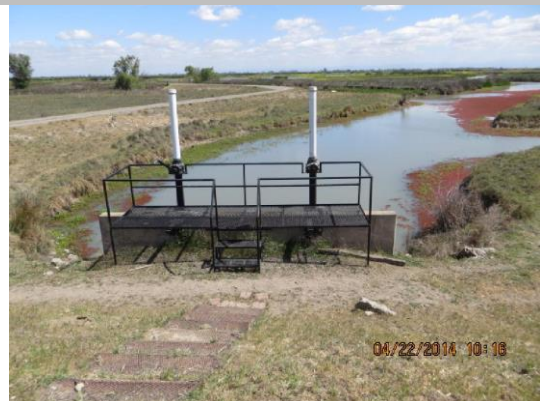
Photo 3 of 3 : UCIP\_SP\_2018\_34267\_62185.jpg

Slide gate mounted on concrete headwall at LS toe.

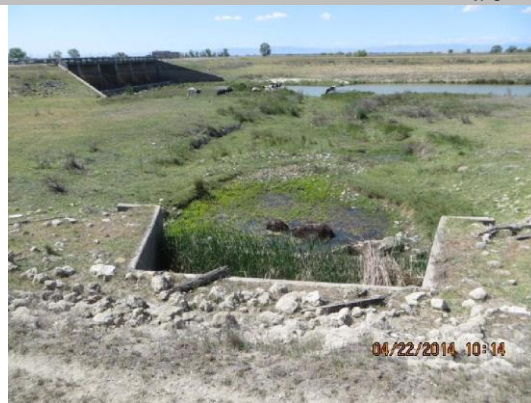
Photo 1 of 3 : UCIP\_SP\_2018\_34268\_62190.jpg

Concrete headwall on WS toe.

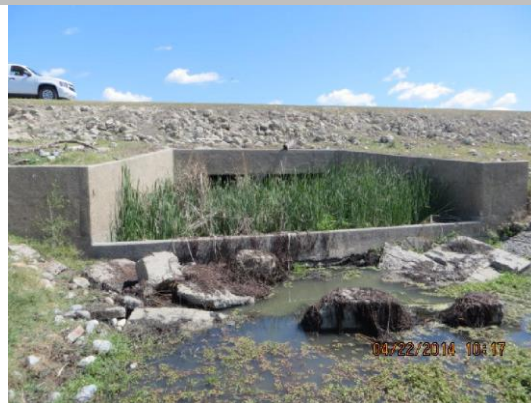
Photo 2 of 3 : UCIP\_SP\_2018\_34268\_62191.jpg

Concrete headwall on WS toe.

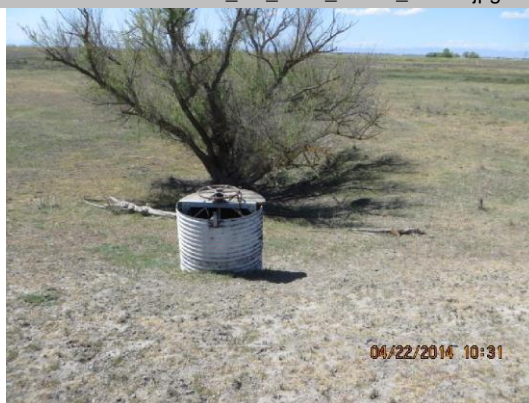
Photo 1 of 3 : UCIP\_SP\_2018\_34272\_62196.jpg

LM Start	9.28	Rating **	A/W	Issue No.	1332
LM End	9.28	Issue Type +	Ma	Location *	
Category	Supplemental			GPS Latitude/Longitude	
				Start	End
Item	DWR UCIP LMA Responsibility			37.202742 °	37.202742 °
				-120.690064 °	-120.690064 °
DWR ID					
Comment Code					
Inspector Comment					
FS_ID:34272					
DS_ID:19766					
EP_NO: N/A					
Repair Type: No Action Needed					
Crossing Status: Found					
UCIP Comments:					
FIELD_STRUCT_DESC: 36-inch corrugated metal gravity drainage pipe through the levee, 14.8 feet below the crown. Slide gate in a 48-inch corrugated metal pipe (CMP) riser on the waterside (WS) slope. Concrete headwall on each end. [Additional Reference(s): DWR Levee Log, 2002. USACE San Joaquin O&M Manual 601.1, 1967, (HLM 9.26)].					
FS Date: 4/22/2014

Slide gate in 48-inch CMP riser on WS slope.

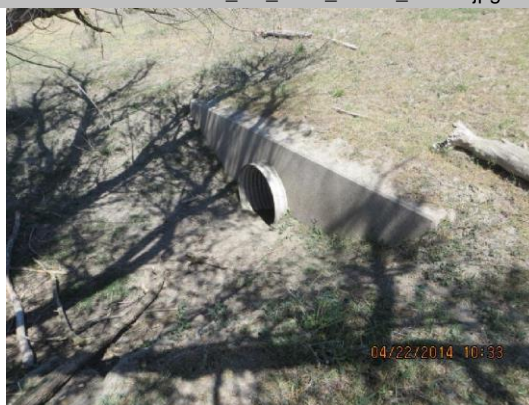
Photo 2 of 3 : UCIP\_SP\_2018\_34272\_62198.jpg

Headwall and pipe at WS toe.

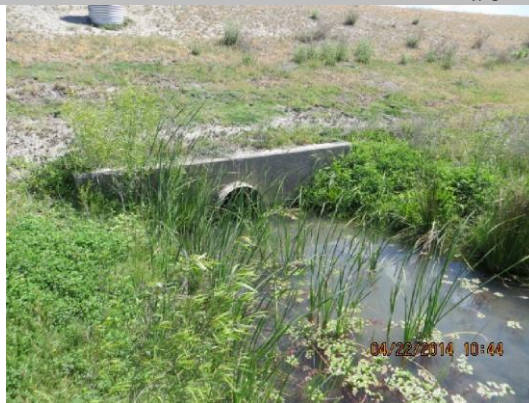
Photo 2 of 3 : UCIP\_SP\_2018\_34273\_62202.jpg

LM Start	10.06	Rating **	M	Issue No.	1333 (cont)	
LM End	10.06	Issue Type +	Ma	Location *		
Category	Supplemental			GPS Latitude/Longitude		
				Start		End
Item	DWR UCIP LMA Responsibility			37.194736 °	37.194736 °	
				-120.680116 °	-120.680116 °	
DWR ID						
Comment Code						
Inspector Comment						
FS_ID:34273						
DS_ID:19767						
EP_NO: N/A						
Repair Type: Non-Urgent						
Crossing Status: Found						
UCIP Comments: Slidegate actuator appears bent and may not work properly (WS slope).						
FIELD_STRUCT_DESC: 24-inch corrugated metal gravity drainage pipe through the levee, 15 feet below the crown. Slide gate in a 36-inch corrugated metal pipe (CMP) riser on the waterside (WS) slope. Concrete headwall on each end. [Additional Reference(s): DWR Levee Log, 2002. USACE San Joaquin O&M Manual 601.1, 1967, (HLM 10.05)].						
FS Date: 4/22/2014

Concrete headwall and pipe on WS toe.

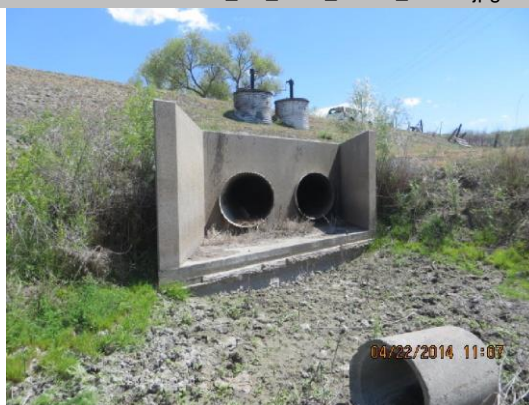
Photo 1 of 3 : UCIP\_SP\_2018\_34281\_62219.jpg

LM Start	11.49	Rating **	A/W	Issue No.	1334
LM End	11.49	Issue Type +	Ma	Location *	
Category	Supplemental			GPS Latitude/Longitude	
				Start	End
Item	DWR UCIP LMA Responsibility			37.186471 °	37.186471 °
				-120.657915 °	-120.657915 °
DWR ID					
Comment Code					
Inspector Comment					
FS_ID:34281 DS_ID:19768 EP_NO: N/A Repair Type: No Action Needed Crossing Status: Found UCIP Comments: FIELD_STRUCT_DESC: [Deadman Drainage Structure] 1 of 2: 48-inch corrugated metal gravity drainage pipe through the levee, 16 feet below the crown. Slide gate in a 60-inch corrugated metal pipe (CMP) riser on the waterside (WS) slope. Concrete U-shaped headwall on each end. Stairs on the landside (LS) slope. [Additional Reference(s): DWR Levee Log, 2002. USACE San Joaquin O&M Manual 601.1, 1967, (HLM 11.48)]. FS Date: 4/22/2014

Slidegate in CMP riser, concrete headwall and pipe visible on WS slope.

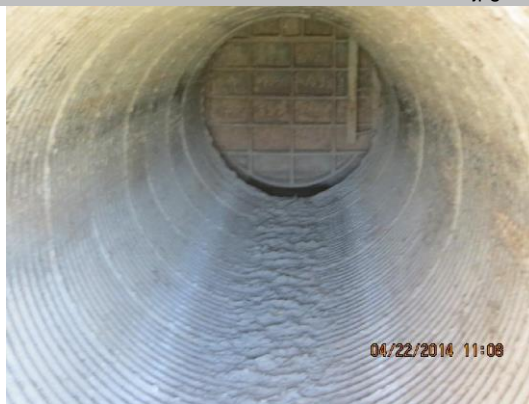
Photo 3 of 3 : UCIP\_SP\_2018\_34281\_62218.jpg

Inside pipe at LS toe.

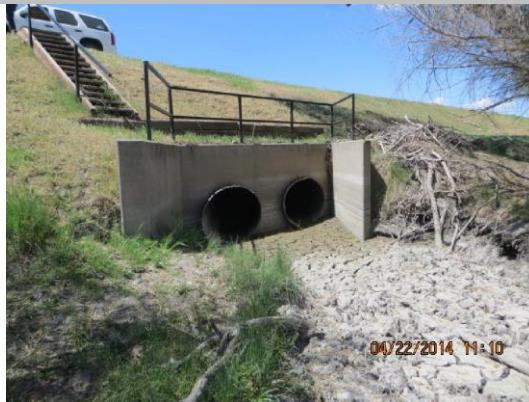
Photo 2 of 3 : UCIP\_SP\_2018\_34280\_62214.jpg

Stairs, concrete headwall and pipe on LS toe.

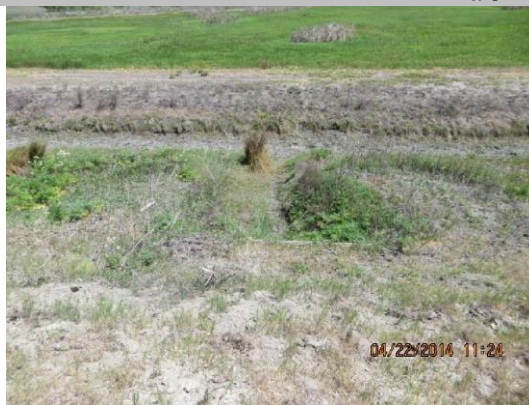
Photo 3 of 3 : UCIP\_SP\_2018\_34283\_62222.jpg

Concrete headwall and pipe at LS toe.

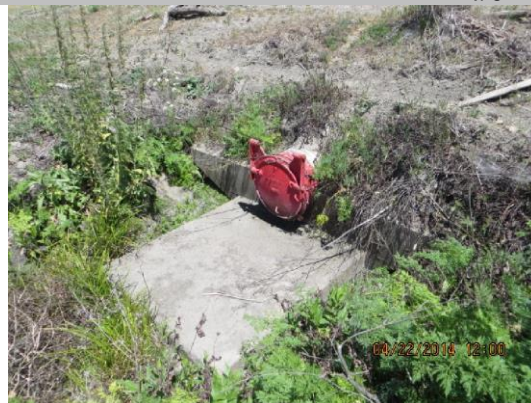
Photo 2 of 3 : UCIP\_SP\_2018\_34284\_62227.jpg

Headwall, flapgate, and pipe on WS toe.

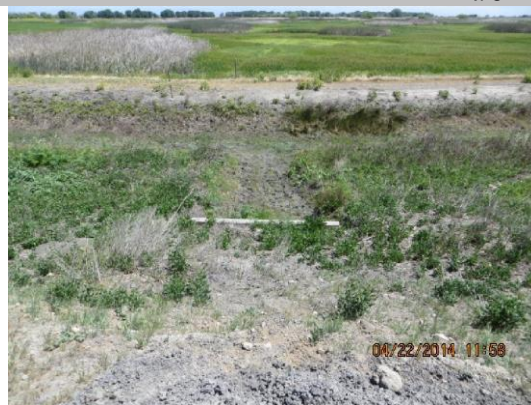
Photo 3 of 3 : UCIP\_SP\_2018\_34284\_62226.jpg

Headwall and pipe on LS toe.

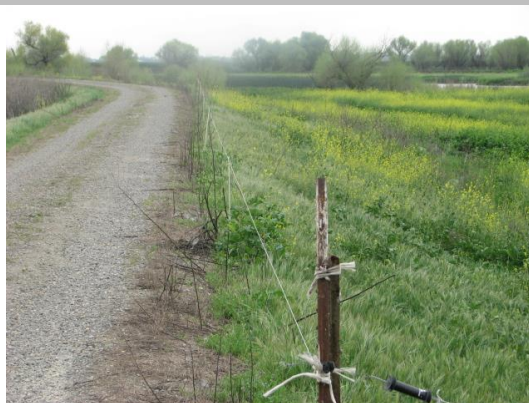
Photo 1 of 1 : SP\_2018\_NA0010\_123\_135\_20180411\_00309.jpg

LM Start	12.25	Rating **	M	Issue No.	135
LM End	13.76	Issue Type +	En	Location *	WS
Category	Earthen Levee			GPS Latitude/Longitude	
				Start	End
Item	Encroachments			37.177671 °	37.167749 °
				-120.651350 °	-120.629438 °
DWR ID	DWR_NA0010_05_s_2018_135				
Comment Code					
FE : Fence					
Inspector Comment					
Electric fence on waterward shoulder.

Looking upstream at electric fence along waterward shoulder. (Spring 2018)

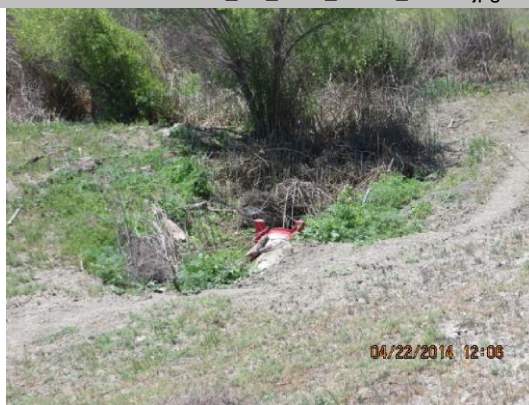
Photo 1 of 3 : UCIP\_SP\_2018\_34285\_62230.jpg

LM Start	12.40	Rating **	A/W	Issue No.	1338
LM End	12.40	Issue Type +	Ma	Location *	
Category	Supplemental			GPS Latitude/Longitude	
				Start	End
Item	DWR UCIP LMA Responsibility			37.175958 °	37.175958 °
				-120.649798 °	-120.649798 °
DWR ID					
Comment Code					
Inspector Comment					
FS_ID:34285 DS_ID:19706 EP_NO: N/A Repair Type: No Action Needed Crossing Status: Found UCIP Comments: FIELD_STRUCT_DESC: 24-inch corrugated metal gravity drainage pipe through the levee, 10.2 feet below the crown. Flap gate on the waterside (WS) end. Concrete headwall on the landside (LS) end. Concrete saddle and apron on the WS end. Flashboard attachment on the LS end. Pipe crosses levee at 45 degrees to crown alignment. [Additional Reference(s): DWR Levee Log, 2002. USACE San Joaquin O&M Manual 601.1, 1967, (HLM 12.38)]. FS Date: 4/22/2014

Headwall, flapgate, and pipe on WS toe.

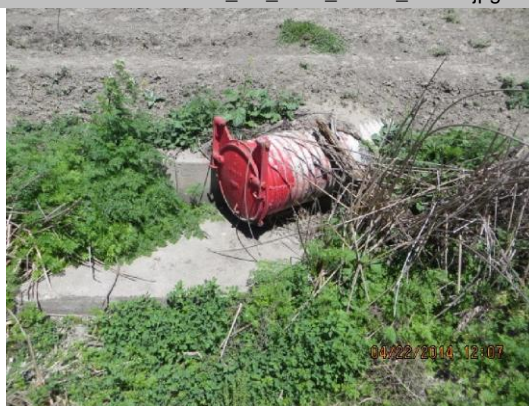
Photo 2 of 3 : UCIP\_SP\_2018\_34285\_62229.jpg

Headwall, flapgate, and pipe on WS toe.

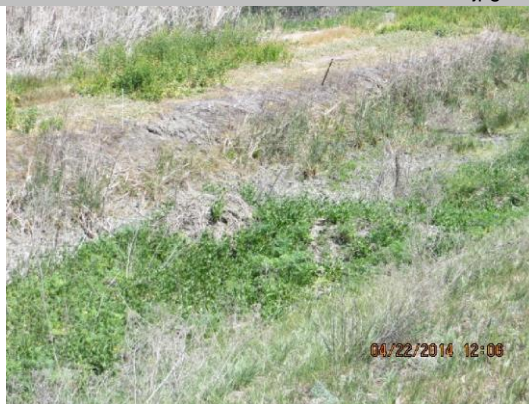
Photo 3 of 3 : UCIP\_SP\_2018\_34285\_62231.jpg

Headwall and pipe on LS toe.

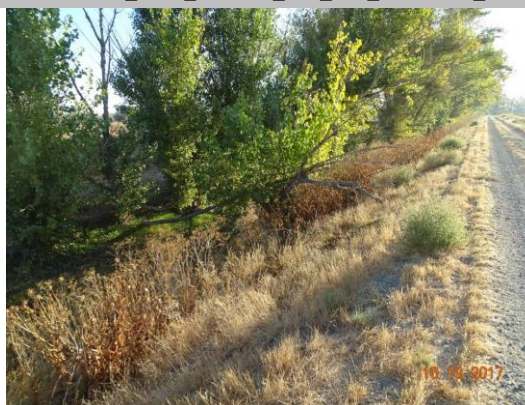
Photo 1 of 1 : SP\_2018\_NA0010\_123\_108\_20180307\_00017.jpg

LM Start	12.81	Rating **	M	Issue No.	108
LM End	12.81	Issue Type +	Ma	Location *	LS
Category	Earthen Levee			GPS Latitude/Longitude	
				Start	End
Item	Encroachments			37.175793 °	37.175793 °
				-120.642227 °	-120.642227 °
DWR ID	DWR_NA0010_05_s _ 2017_108				
Comment Code					
TR : Tree or limb					
Inspector Comment

Looking east at the landside slope.

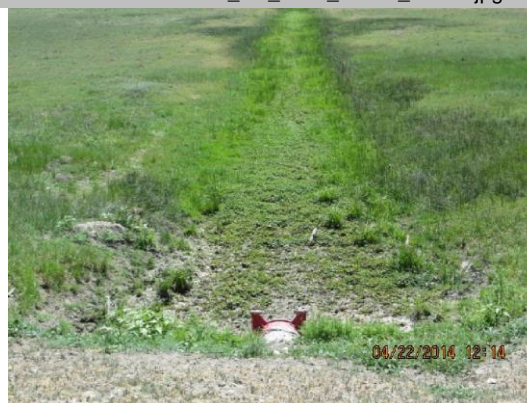
Photo 1 of 3 : UCIP\_SP\_2018\_39593\_62240.jpg

Comment Code						
Inspector Comment						
FS_ID:39593						
DS_ID:19707						
EP_NO: N/A						
Repair Type: Non-Urgent						
Crossing Status: Found						
UCIP Comments: Sediment buildup in pipe visible from landward side--recommend contacting owner to clear pipe.						
FIELD_STRUCT_DESC: 24-inch corrugated metal gravity drainage pipe through the levee, 10.2 feet below the crown. Concrete headwall on the landside (LS) end with flashboards. Concrete saddle and apron on the waterside (WS) end with a flap gate. Metal screen at LS toe inlet.						
[Additional Reference(s): DWR Levee Log, 2002. USACE San Joaquin O&M Manual 601.1, 1967, (HLM 12.87)].						
FS Date: 4/22/2014

Headwall, flapgate, and pipe on WS toe.

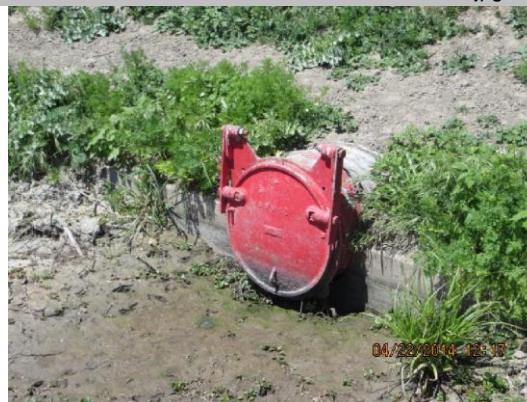
Photo 2 of 3 : UCIP\_SP\_2018\_39593\_62241.jpg

Headwall, flapgate, and pipe on WS toe.

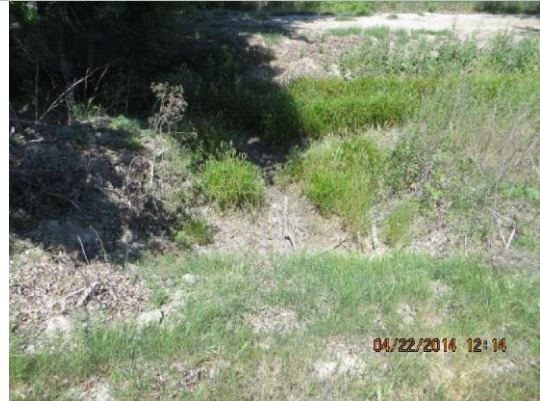
Photo 3 of 3 : UCIP\_SP\_2018\_39593\_62239.jpg

Headwall and pipe on LS toe.

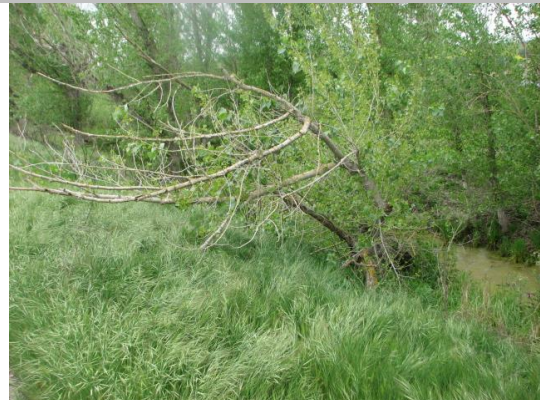
Photo 1 of 1 : SP\_2018\_NA0010\_123\_109\_20180411\_00310.jpg

LM Start	12.93	Rating **	M	Issue No.	109
LM End	12.93	Issue Type +	Ma	Location *	LS
Category	Earthen Levee			GPS Latitude/Longitude	
				Start	End
Item	Encroachments			37.175780 °	37.175780 °
				-120.640195 °	-120.640195 °
DWR ID	DWR_NA0010_05_s_2017_109				
Comment Code					
TR : Tree or limb					
Inspector Comment					
Fallen tree on landside toe.

Looking at broken tree on landward toe. (Spring 2018)

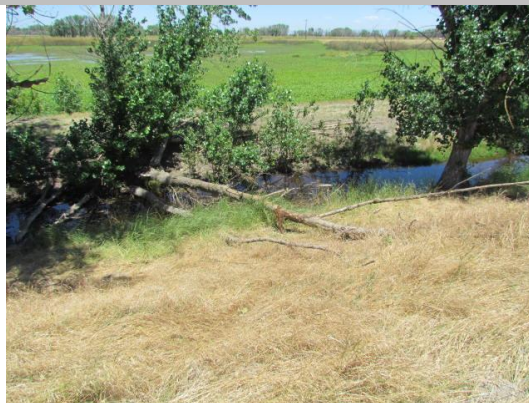
Photo 1 of 1 : SP\_2018\_NA0010\_123\_2\_20180307\_00005.jpg

LM Start	13.01	Rating **	M	Issue No.	2	
LM End	13.01	Issue Type +	Ma	Location *	LS	
Category	Earthen Levee			GPS Latitude/Longitude		
				Start		End
Item	Encroachments			37.175576 °		37.175576 °
				-120.638755 °		-120.638755 °
DWR ID	DWR_NA0010_05_s _ 2016_2					
Comment Code						
TR : Tree or limb						
Inspector Comment						
Downed tree on landside toe.

Looking west at down tree at landward toe.

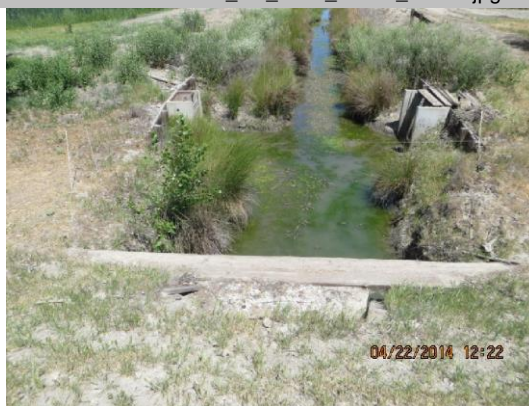
Photo 1 of 3 : UCIP\_SP\_2018\_34288\_62244.jpg

LM Start	13.42	Rating **	M	Issue No.	1340
LM End	13.42	Issue Type +	Ma	Location *	
Category	Supplemental			GPS Latitude/Longitude	
				Start	End
Item	DWR UCIP LMA Responsibility			37.171523 °	37.171523 °
				-120.633442 °	-120.633442 °
DWR ID					
Comment Code					
Inspector Comment					
FS_ID:34288 DS_ID:19708 EP_NO: N/A Repair Type: Non-Urgent Crossing Status: Found UCIP Comments: Some erosion around headwall on the WS toe and there are animal burrows on both slopes. FIELD_STRUCT_DESC: 48-inch corrugated metal gravity drainage pipe through the levee, 10 feet below the crown. Flap gate on the waterside (WS) end. Flashboard attachment in concrete U-shaped headwall on the landside (LS) end. Concrete U-shaped headwall on the WS end. [Additional Reference(s): DWR Levee Log, 2002. USACE San Joaquin O&M Manual 601.1, 1967, (HLM 13.40)]. FS Date: 4/22/2014

Headwall and pipe on LS toe.

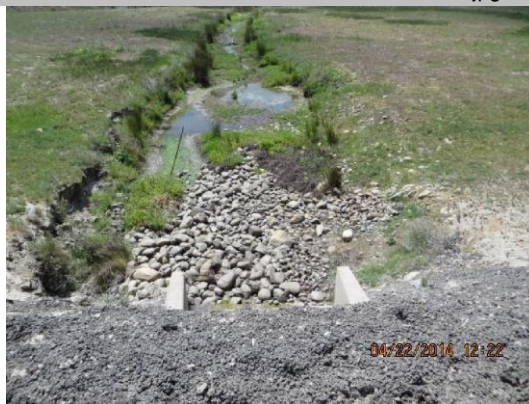
Photo 2 of 3 : UCIP\_SP\_2018\_34288\_62243.jpg

Headwall, flapgate, and pipe on WS toe.

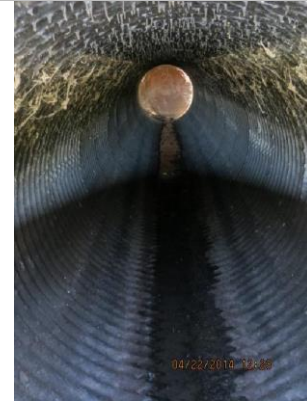
Photo 3 of 3 : UCIP\_SP\_2018\_34288\_62242.jpg

LM Start	13.42	Rating **	M	Issue No.	1340 (cont)	
LM End	13.42	Issue Type +	Ma	Location *		
Category	Supplemental			GPS Latitude/Longitude		
				Start	End	
Item	DWR UCIP LMA Responsibility			37.171523 °	37.171523 °	
				-120.633442 °	-120.633442 °	
DWR ID						
Comment Code						
Inspector Comment						
FS_ID:34288 DS_ID:19708 EP_NO: N/A Repair Type: Non-Urgent Crossing Status: Found UCIP Comments: Some erosion around headwall on the WS toe and there are animal burrows on both slopes. FIELD_STRUCT_DESC: 48-inch corrugated metal gravity drainage pipe through the levee, 10 feet below the crown. Flap gate on the waterside (WS) end. Flashboard attachment in concrete U-shaped headwall on the landside (LS) end. Concrete U-shaped headwall on the WS end. [Additional Reference(s): DWR Levee Log, 2002. USACE San Joaquin O&M Manual 601.1, 1967, (HLM 13.40)]. FS Date: 4/22/2014

Headwall, flapgate, and pipe on WS toe.

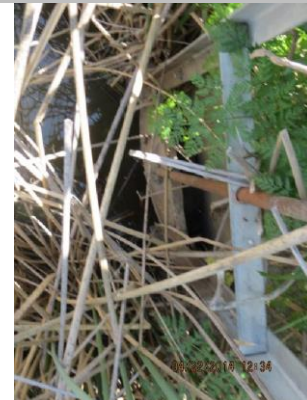
Photo 1 of 2 : UCIP\_SP\_2018\_34824\_62624.jpg

LM Start	13.72	Rating **	M	Issue No.	1341	
LM End	13.72	Issue Type +	Ma	Location *		
Category	Supplemental			GPS Latitude/Longitude		
				Start		End
Item	DWR UCIP LMA Responsibility			37.168202 °		37.168202 °
				-120.629886 °		-120.629886 °
DWR ID						
Comment Code						
Inspector Comment						
FS_ID:34824 DS_ID:19709 EP_NO: N/A Repair Type: Non-Urgent Crossing Status: Found UCIP Comments: Pipe not visible and may need to have silt removed from outlet on WS toe. FIELD_STRUCT_DESC: 24-inch corrugated metal gravity drainage pipe through the levee, 16 feet below the crown. Flap gate on the waterside (WS) end. Slide gate on concrete headwall at the landside (LS) toe. Concrete saddle and apron on the WS end. [Additional Reference(s): DWR Levee Log, 2002. USACE San Joaquin O&M Manual 601.1, 1967, (HLM 13.72)]. FS Date: 4/22/2014

Slide gate at concrete headwall on LS toe.

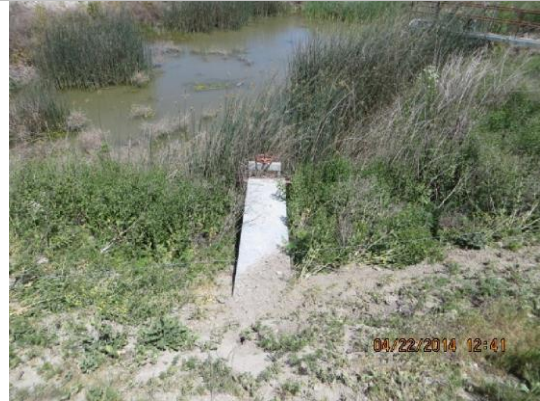
Photo 2 of 2 : UCIP\_SP\_2018\_34824\_62623.jpg

LM Start	13.72	Rating **	M	Issue No.	1341 (cont)
LM End	13.72	Issue Type +	Ma	Location *	
Category	Supplemental			GPS Latitude/Longitude	
				Start	End
Item	DWR UCIP LMA Responsibility			37.168202 °	37.168202 °
				-120.629886 °	-120.629886 °
DWR ID					
Comment Code					
Inspector Comment					
FS_ID:34824 DS_ID:19709 EP_NO: N/A Repair Type: Non-Urgent Crossing Status: Found UCIP Comments: Pipe not visible and may need to have silt removed from outlet on WS toe. FIELD_STRUCT_DESC: 24-inch corrugated metal gravity drainage pipe through the levee, 16 feet below the crown. Flap gate on the waterside (WS) end. Slide gate on concrete headwall at the landside (LS) toe. Concrete saddle and apron on the WS end. [Additional Reference(s): DWR Levee Log, 2002. USACE San Joaquin O&M Manual 601.1, 1967, (HLM 13.72)]. FS Date: 4/22/2014

Walkway to gatevalve on LS shoulder.

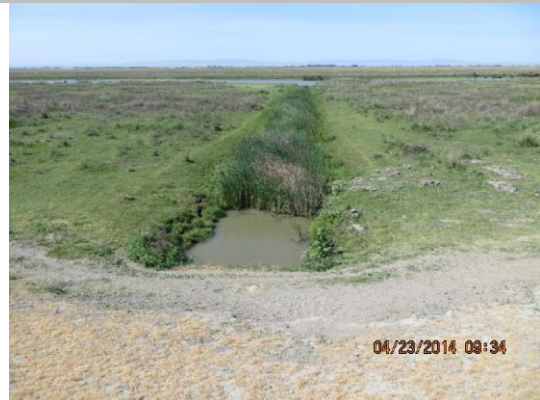
Photo 1 of 3 : UCIP\_SP\_2018\_34657\_62450.jpg

LM Start	13.85	Rating **	A/W	Issue No.	1342
LM End	13.85	Issue Type +	Ma	Location *	
Category	Supplemental			GPS Latitude/Longitude	
				Start	End
Item	DWR UCIP LMA Responsibility			37.166760 °	37.166760 °
				-120.628304 °	-120.628304 °
DWR ID					
Comment Code					
Inspector Comment					
FS_ID:34657					
DS_ID:19710					
EP_NO: N/A					
Repair Type: No Action Needed					
Crossing Status: Found					
UCIP Comments:					
FIELD_STRUCT_DESC: 24-inch corrugated metal gravity drainage pipe					
through the levee, 12.4 feet below the crown. Flap gate on the					
waterside (WS) end. Concrete headwall on each end. [Additional					
Reference(s): DWR Levee Log, 2002. USACE San Joaquin O&M					
Manual 601.1, 1967, (HLM 13.83)].					
FS Date: 4/23/2014 4:17:00 PM

Headwall, flapgate, and pipe on WS toe.

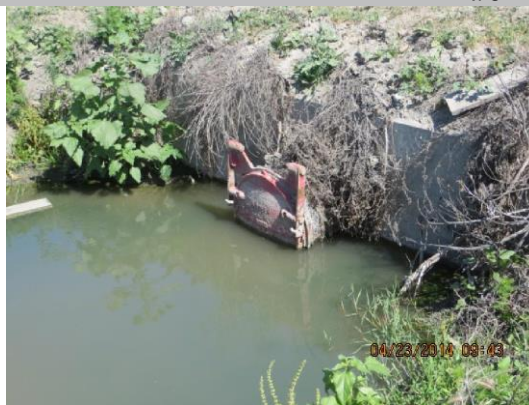
Photo 2 of 3 : UCIP\_SP\_2018\_34656\_62447.jpg

Headwall, pipe, and flapgate on WS toe.

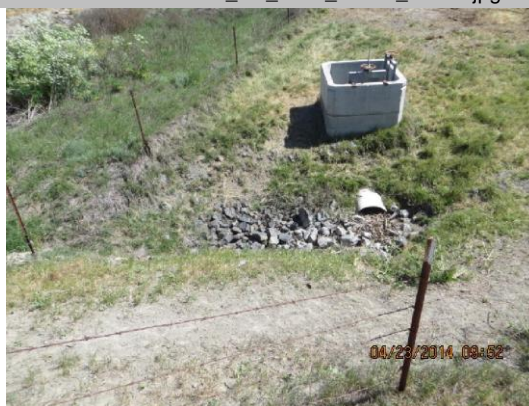
Photo 1 of 3 : UCIP\_SP\_2018\_34664\_62454.jpg

LM Start	15.11	Rating **	M	Issue No.	1344
LM End	15.11	Issue Type +	Ma	Location *	
Category	Supplemental			GPS Latitude/Longitude	
				Start	End
Item	DWR UCIP LMA Responsibility			37.156805 °	37.156805 °
				-120.609513 °	-120.609513 °
DWR ID					
Comment Code					
Inspector Comment					
FS_ID:34664 DS_ID:19712 EP_NO: N/A Repair Type: Non-Urgent Crossing Status: Found UCIP Comments: Minor erosion at headwall on WS toe. FIELD_STRUCT_DESC: 36-inch corrugated metal gravity drainage pipe through the levee, 11.9 feet below the crown. Flap gate on the waterside (WS) end. Concrete headwall on each end. [Additional Reference(s): DWR Levee Log, 2002. USACE San Joaquin O&M Manual 601.1, 1967, (HLM 15.09)]. FS Date: 4/23/2014

Headwall and inlet on LS toe.

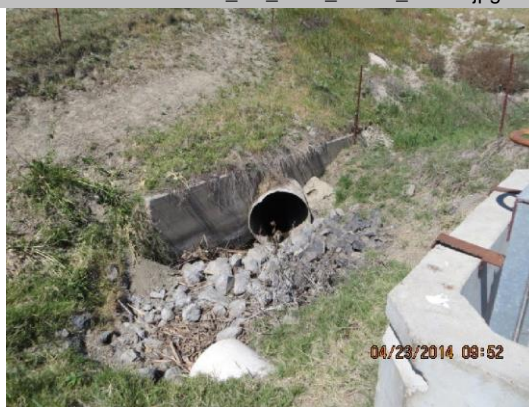
Photo 2 of 3 : UCIP\_SP\_2018\_34664\_62453.jpg

Headwall and inlet on LS toe.
