**Flood Control Project Maintenance  
Levee Inspections**  
**LMA District Cover Sheet**  
**Spring 2018 Levee Inspection Results**

**Lower San Joaquin Levee District**

**Spring 2018 Levee Inspection Results**

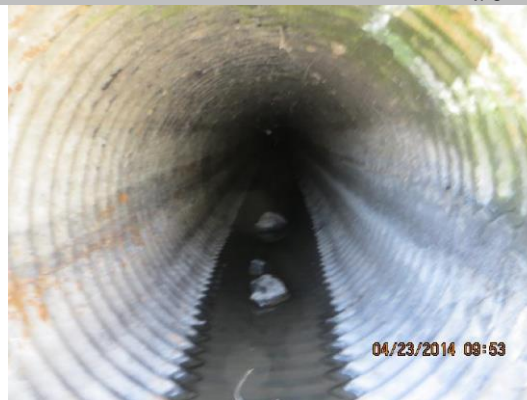
Photo 3 of 3 : UCIP\_SP\_2018\_34664\_62452.jpg

LM Start	15.11	Rating **	M	Issue No.	1344 (cont)	
LM End	15.11	Issue Type +	Ma	Location *		
Category	Supplemental			GPS Latitude/Longitude		
				Start	End	
Item	DWR UCIP LMA Responsibility			37.156805 °	37.156805 °	
				-120.609513 °	-120.609513 °	
DWR ID						
Comment Code						
Inspector Comment						
FS_ID:34664						
DS_ID:19712						
EP_NO: N/A						
Repair Type: Non-Urgent						
Crossing Status: Found						
UCIP Comments: Minor erosion at headwall on WS toe.						
FIELD_STRUCT_DESC: 36-inch corrugated metal gravity drainage pipe						
through the levee, 11.9 feet below the crown. Flap gate on the						
waterside (WS) end. Concrete headwall on each end. [Additional						
Reference(s): DWR Levee Log, 2002. USACE San Joaquin O&M						
Manual 601.1, 1967, (HLM 15.09)].						
FS Date: 4/23/2014

Inside pipe at LS toe.

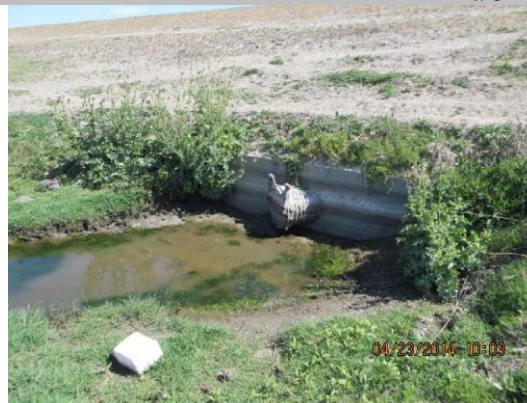
Photo 1 of 3 : UCIP\_SP\_2018\_39595\_62459.jpg

LM Start	15.76	Rating **	M	Issue No.	1345
LM End	15.76	Issue Type +	En	Location *	
Category	Supplemental			GPS Latitude/Longitude	
				Start	End
Item	DWR UCIP Field Study			37.150012 °	37.150012 °
				-120.601330 °	-120.601330 °
DWR ID					
Comment Code					
Inspector Comment					
FS_ID:39595 DS_ID:19713 EP_NO: N/A Repair Type: Non-Urgent Crossing Status: Found UCIP Comments: Sediment buildup in pipe visible from landward side--recommend contacting owner to clear pipe. FIELD_STRUCT_DESC: 24-inch corrugated metal gravity drainage pipe through the levee, 11 feet below the crown. Flap gate on the waterside (WS) end. Concrete headwall on each end. [Additional Reference(s): DWR Levee Log, 2002. USACE San Joaquin O&M Manual 601.1, 1967, (HLM 15.74)]. FS Date: 4/23/2014

Headwall, pipe, and flapgate on WS toe.

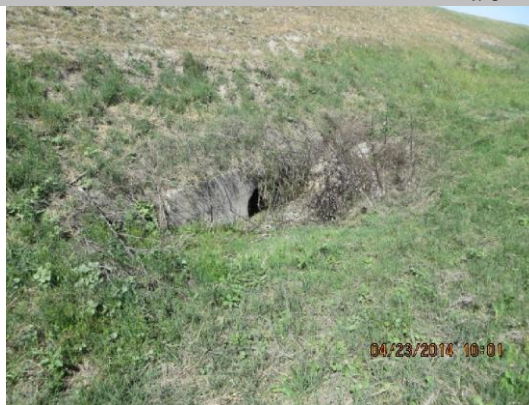
Photo 3 of 3 : UCIP\_SP\_2018\_39595\_62458.jpg

Headwall and pipe at LS toe.

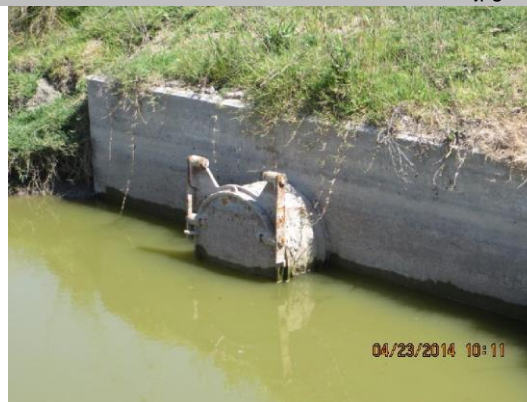
Photo 2 of 3 : UCIP\_SP\_2018\_39596\_62467.jpg

Headwall, pipe, and flapgate on WS toe.

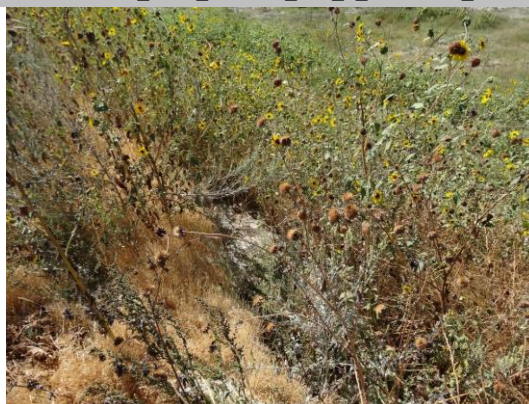
Photo 1 of 4 : SP\_2018\_NA0010\_123\_1\_20180307\_00001.jpg

LM Start	16.11	Rating **	M	Issue No.	1
LM End	16.12	Issue Type +	Ma	Location *	WS
Category	Supplemental			GPS Latitude/Longitude	
				Start	End
Item	DWR Erosion Survey			37.145965 °	37.145965 °
				-120.597597 °	-120.597597 °
DWR ID	NA0010U05RM13.85				
Comment Code					
Inspector Comment					
09/20/2017: The erosion was discovered during spring levee inspection. The site is covered by dense vegetation and the measurements of the erosion are estimated. [2017 Site ID:NA0010U05RM13.85]

Looking down at the erosion from the levee top. Note the dense vegetation.

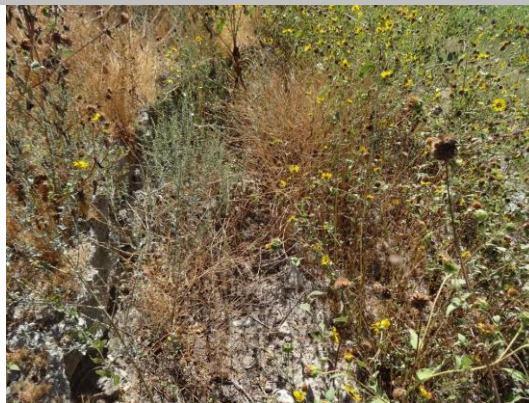
Photo 2 of 4 : SP\_2018\_NA0010\_123\_1\_20180307\_00002.jpg

Close view of the erosion.

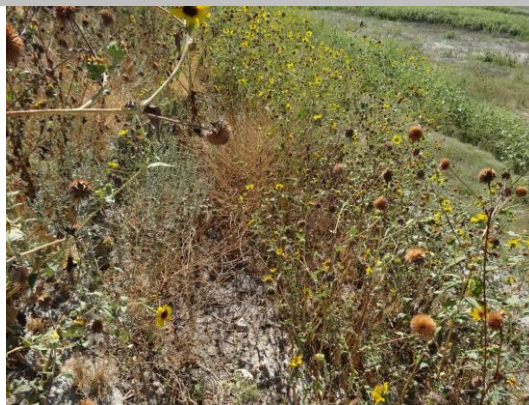
Photo 3 of 4 : SP\_2018\_NA0010\_123\_1\_20180307\_00003.jpg

Close view of the erosion.

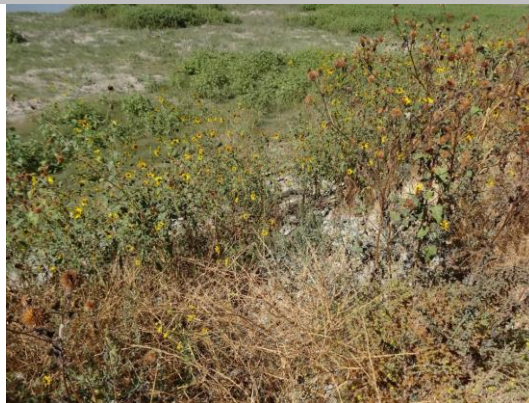
Photo 4 of 4 : SP\_2018\_NA0010\_123\_1\_20180307\_00004.jpg

Looking down at the erosion.

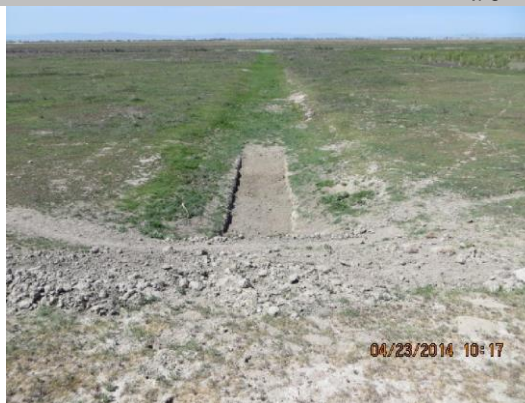
Photo 1 of 3 : UCIP\_SP\_2018\_34725\_62469.jpg

LM Start	16.68	Rating **	M	Issue No.	1347	
LM End	16.68	Issue Type +	Ma	Location *		
Category	Supplemental			GPS Latitude/Longitude		
				Start	End	
Item	DWR UCIP LMA Responsibility			37.138760 °	37.138760 °	
				-120.592393 °	-120.592393 °	
DWR ID						
Comment Code						
Inspector Comment						
FS_ID:34725 DS_ID:19716 EP_NO: N/A Repair Type: Non-Urgent Crossing Status: Found UCIP Comments: Pipe heavily silted on LS toe. FIELD_STRUCT_DESC: 24-inch corrugated metal gravity drainage pipe through the levee, 10.5 feet below the crown. Flap gate on the waterside (WS) end. Concrete headwall on each end. [Additional Reference(s): DWR Levee Log, 2002. USACE San Joaquin O&M Manual 601.1, 1967, (HLM 16.67)]. FS Date: 4/23/2014

Headwall, flapgate, and pipe visible on WS toe.

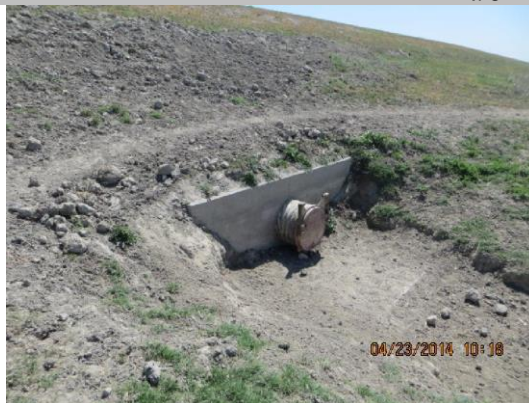
Photo 2 of 3 : UCIP\_SP\_2018\_34725\_62471.jpg

Headwall, flapgate, and pipe visible on WS toe.

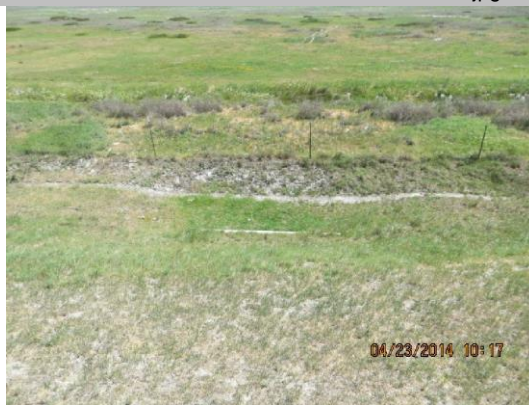
Photo 3 of 3 : UCIP\_SP\_2018\_34725\_62470.jpg

Concrete headwall and pipe visible on LS toe.

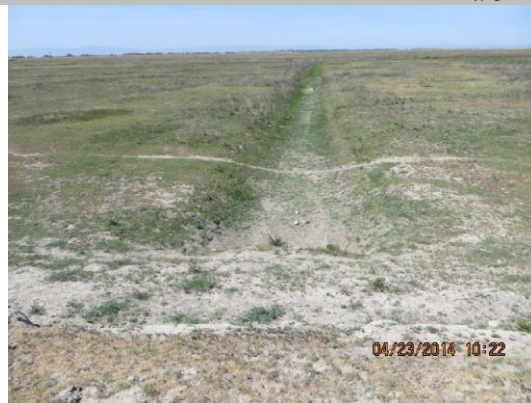
Photo 1 of 3 : UCIP\_SP\_2018\_39597\_62481.jpg

LM Start	17.22	Rating **	M	Issue No.	1348	
LM End	17.22	Issue Type +	Ma	Location *		
Category	Supplemental			GPS Latitude/Longitude		
				Start	End	
Item	DWR UCIP LMA Responsibility			37.132211 °	37.132211 °	
				-120.587106 °	-120.587106 °	
DWR ID						
Comment Code						
Inspector Comment						
FS_ID:39597 DS_ID:19717 EP_NO: N/A Repair Type: Non-Urgent Crossing Status: Found UCIP Comments: Sediment buildup in pipe visible from landward side--recommend contacting owner to clear pipe. FIELD_STRUCT_DESC: 24-inch corrugated metal gravity drainage pipe through the levee, 12 feet below the crown. Flap gate on the waterside (WS) end. Concrete headwall on each end. [Additional Reference(s): DWR Levee Log, 2002. USACE San Joaquin O&M Manual 601.1, 1967, (HLM 17.20)]. FS Date: 4/23/2014

Headwall, flapgate, and pipe visible on WS toe.

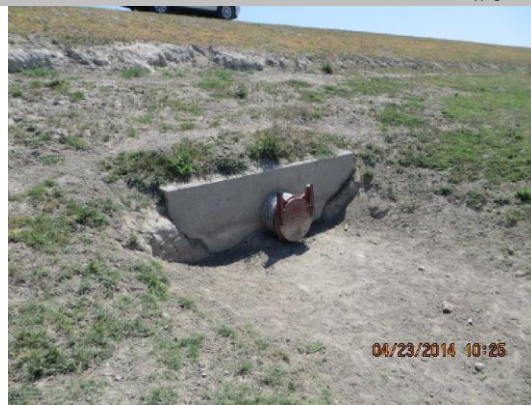
Photo 2 of 3 : UCIP\_SP\_2018\_39597\_62483.jpg

Headwall, flapgate, and pipe visible on WS toe.

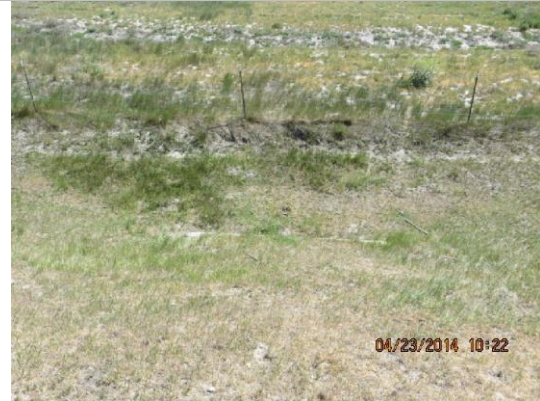
Photo 3 of 3 : UCIP\_SP\_2018\_39597\_62482.jpg

Headwall and pipe visible on LS toe.

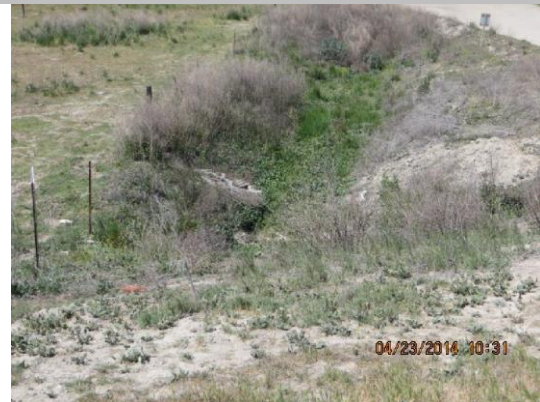
Photo 1 of 3 : UCIP\_SP\_2018\_39599\_62485.jpg

LM Start	17.54	Rating **	M	Issue No.	1349
LM End	17.54	Issue Type +	Ma	Location *	
Category	Supplemental			GPS Latitude/Longitude	
				Start	End
Item	DWR UCIP LMA Responsibility			37.127843 °	37.127843 °
				-120.585245 °	-120.585245 °
DWR ID					
Comment Code					
Inspector Comment					
FS_ID:39599 DS_ID:19743 EP_NO: N/A Repair Type: Non-Urgent Crossing Status: Found UCIP Comments: Sediment buildup in pipe visible from landward side--recommend contacting owner to clear pipe. FIELD_STRUCT_DESC: 24-inch corrugated metal gravity drainage pipe through the levee, 9.8 feet below the crown. Flap gate on the waterside (WS) end. Concrete headwall on each end. [Additional Reference(s): DWR Levee Log, 2002. USACE San Joaquin O&M Manual 601.1, 1967, (HLM 17.52)]. FS Date: 4/23/2014

Headwall, pipe, and flapgate visible on WS toe.

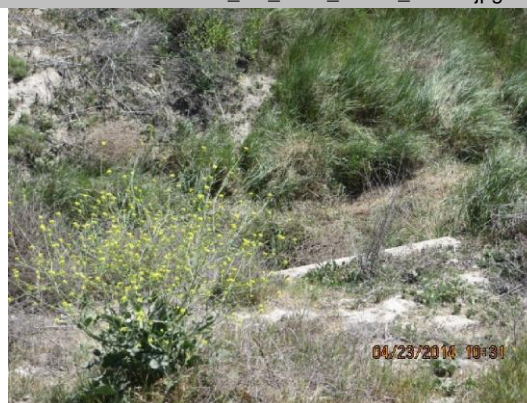
Photo 2 of 3 : UCIP\_SP\_2018\_39599\_62486.jpg

Pipe and headwall visible on LS toe.

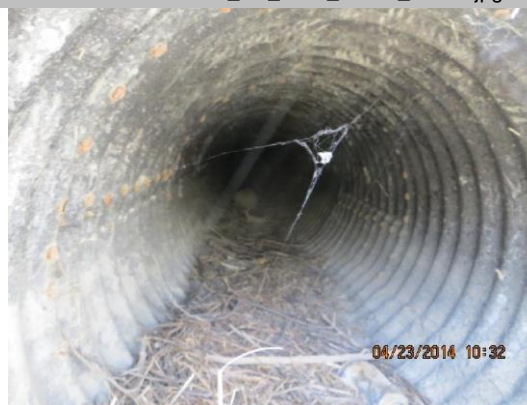
Photo 3 of 3 : UCIP\_SP\_2018\_39599\_62488.jpg

Inside pipe on LS toe.

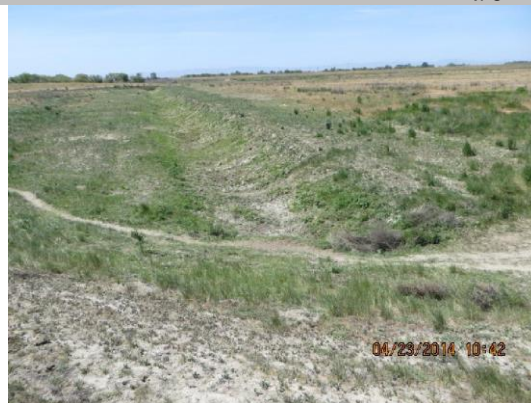
Photo 1 of 3 : UCIP\_SP\_2018\_34747\_62494.jpg

LM Start	18.09	Rating **	M	Issue No.	1350
LM End	18.09	Issue Type +	Ma	Location *	
Category	Supplemental			GPS Latitude/Longitude	
				Start	End
Item	DWR UCIP LMA Responsibility			37.120309 °	37.120309 °
				-120.582041 °	-120.582041 °
DWR ID					
Comment Code					
Inspector Comment					
FS_ID:34747					
DS_ID:19745					
EP_NO: N/A					
Repair Type: Non-Urgent					
Crossing Status: Found					
UCIP Comments: Animal burrows in levee on both slopes.					
FIELD_STRUCT_DESC: 24-inch corrugated metal gravity drainage pipe					
through the levee, 12.4 feet below the crown. Flap gate on the					
waterside (WS) end. Concrete headwall on each end. [Additional					
Reference(s): DWR Levee Log, 2002. USACE San Joaquin O&M					
Manual 601.1, 1967, (HLM 18.07)].					
FS Date: 4/23/2014

Headwall, pipe, and flapgate on WS toe.

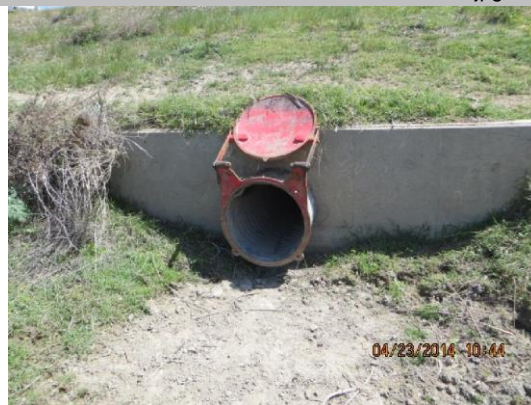
Photo 2 of 3 : UCIP\_SP\_2018\_34747\_62495.jpg

Headwall, pipe, and flapgate on WS toe.

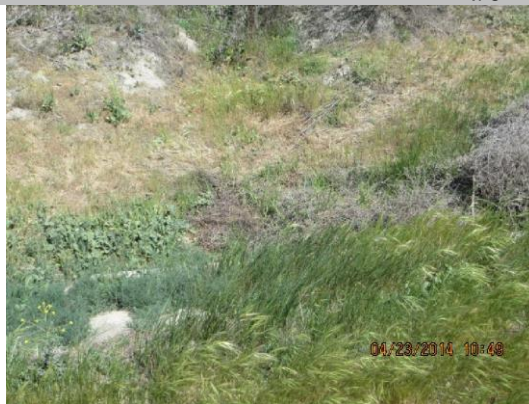
Photo 3 of 3 : UCIP\_SP\_2018\_39600\_62500.jpg

Headwall and pipe on LS toe.

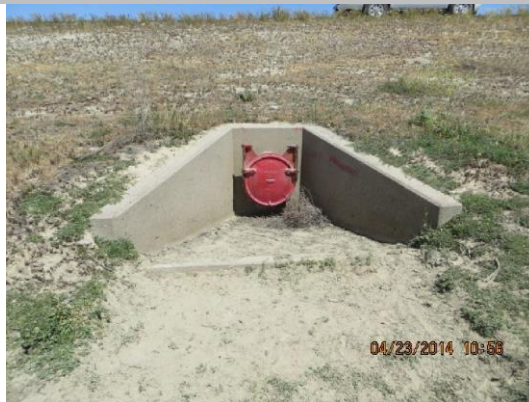
Photo 2 of 3 : UCIP\_SP\_2018\_39601\_62506.jpg

Headwall, pipe, and flapgate visible on WS toe.

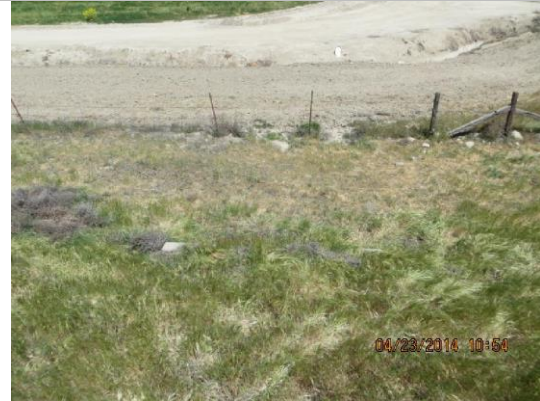
Photo 3 of 3 : UCIP\_SP\_2018\_39601\_62505.jpg

Headwall and pipe visible on LS toe.

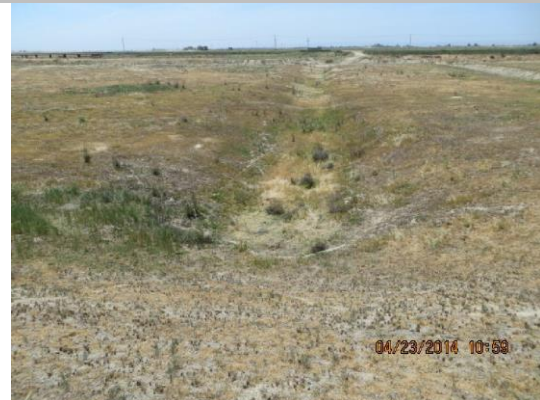
Photo 1 of 3 : UCIP\_SP\_2018\_34751\_62509.jpg

LM Start	19.17	Rating **	A/W	Issue No.	1353
LM End	19.17	Issue Type +	Ma	Location *	
Category	Supplemental			GPS Latitude/Longitude	
				Start	End
Item	DWR UCIP LMA Responsibility			37.115463 °	37.115463 °
				-120.565086 °	-120.565086 °
DWR ID					
Comment Code					
Inspector Comment					
FS_ID:34751 DS_ID:19776 EP_NO: N/A Repair Type: No Action Needed Crossing Status: Found UCIP Comments: FIELD_STRUCT_DESC: 24-inch corrugated metal gravity drainage pipe through the levee, 10.3 feet below the crown. Flap gate on the waterside (WS) end. Concrete headwall on the landside (LS) end. Concrete U-shaped headwall on the WS end. [Additional Reference(s): DWR Levee Log, 2002. USACE San Joaquin O&M Manual 601.1, 1967, (HLM 19.15)]. FS Date: 4/23/2014

Headwall, pipe, and flapgate visible on WS toe.

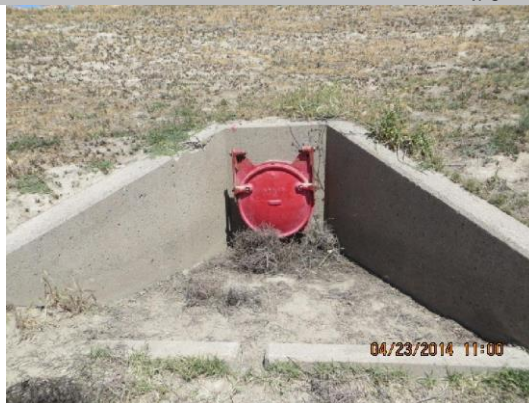
Photo 2 of 3 : UCIP\_SP\_2018\_34751\_62511.jpg

Headwall, pipe, and flapgate visible on WS toe.

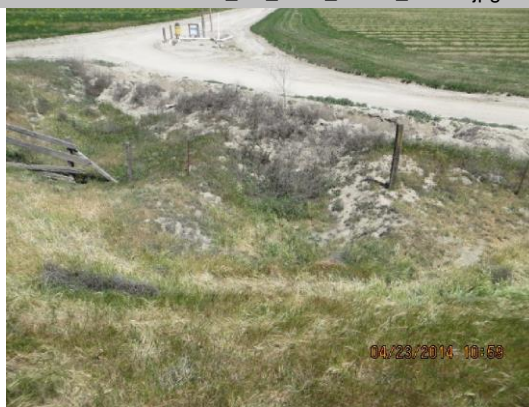
Photo 3 of 3 : UCIP\_SP\_2018\_34751\_62510.jpg

Headwall and pipe visible on LS toe.

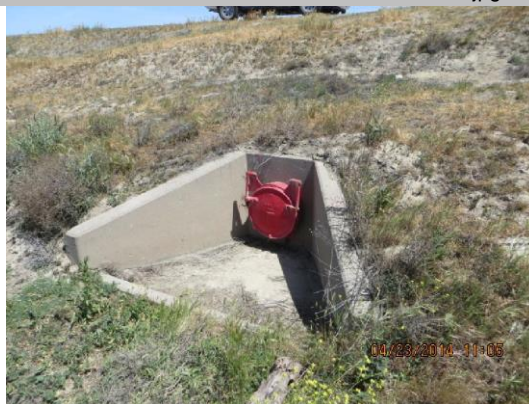
Photo 2 of 3 : UCIP\_SP\_2018\_39602\_62516.jpg

Headwall, pipe, and flapgate visible on WS toe.

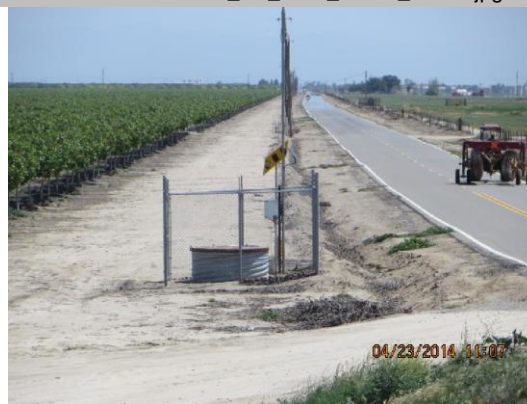
Photo 1 of 2 : UCIP\_SP\_2018\_39345\_71477.jpg

LM Start	19.51	Rating **	M	Issue No.	1355
LM End	19.51	Issue Type +	En	Location *	
Category	Supplemental			GPS Latitude/Longitude	
				Start	End
Item	DWR UCIP Field Study			37.113172 °	37.113172 °
				-120.560014 °	-120.560014 °
DWR ID					
Comment Code					
Inspector Comment					
FS_ID:39345					
DS_ID:24868					
EP_NO: N/A					
Repair Type: Non-Urgent					
Crossing Status: Indicator Found					
UCIP Comments: Markers closer to the levee may be necessary to properly mark pipe crossing location.					
FIELD_STRUCT_DESC: Steel natural gas pipeline of an unknown size through the levee, at an unknown depth. Corrugated metal pipe (CMP) riser and gas line marker off the landside (LS) toe.					
FS Date: 4/22/2014

Gasline marker off LS toe.

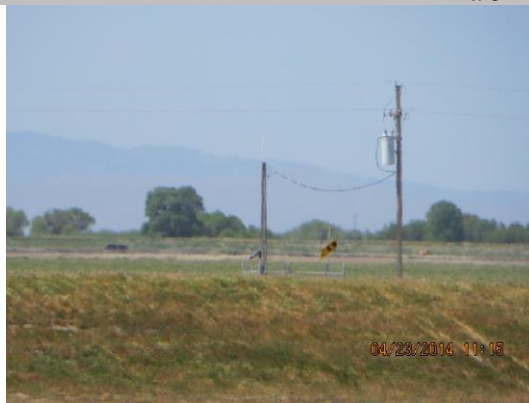
Photo 2 of 2 : UCIP\_SP\_2018\_39345\_71476.jpg

LM Start	<b>19.51</b>	Rating **	M	Issue No.	<b>1355 (cont)</b>
LM End	<b>19.51</b>	Issue Type +	En	Location *	
Category	Supplemental		GPS Latitude/Longitude		
			Start	End	
Item	DWR UCIP Field Study		37.113172 °	37.113172 °	
			-120.560014 °	-120.560014 °	
DWR ID					
Comment Code					
Inspector Comment					
FS_ID:39345 DS_ID:24868 EP_NO: N/A Repair Type: Non-Urgent Crossing Status: Indicator Found UCIP Comments: Markers closer to the levee may be necessary to properly mark pipe crossing location. FIELD_STRUCT_DESC: Steel natural gas pipeline of an unknown size through the levee, at an unknown depth. Corrugated metal pipe (CMP) riser and gas line marker off the landside (LS) toe. FS Date: 4/22/2014

Gasline marker off LS of opposite bank.

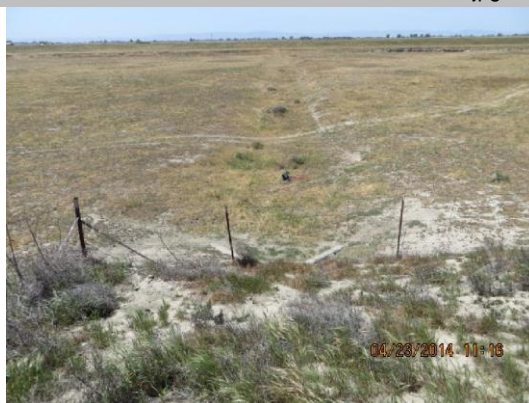
Photo 1 of 3 : UCIP\_SP\_2018\_39603\_62519.jpg

Item	DWR UCIP LMA Responsibility		37.112953 °	37.112953 °	
			-120.559943 °	-120.559943 °	
DWR ID					
Comment Code					
Inspector Comment					
FS_ID:39603 DS_ID:19778 EP_NO: N/A Repair Type: Non-Urgent Crossing Status: Found UCIP Comments: Dense vegetation limits the inspector's visibility to identify signs of pipe failure (leaks) along the landward slope. Recommend removing vegetation along pipe alignment to conduct proper inspection of structure. Sediment buildup in pipe visible from landward side--recommend contacting owner to clear pipe. FIELD_STRUCT_DESC: 24-inch corrugated metal gravity drainage pipe through the levee, 9.7 feet below the crown. Flap gate on the waterside (WS) end. Concrete headwall on the landside (LS) end. Concrete U-shaped headwall on the WS end. [Additional Reference(s): DWR Levee Log, 2002. USACE San Joaquin O&M Manual 601.1, 1967, (HLM 19.50)]. FS Date: 4/23/2014

Headwall, pipe, and flapgate visible on WS toe.

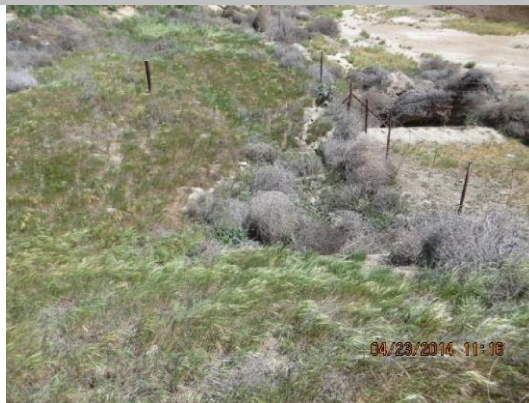
Photo 3 of 3 : UCIP\_SP\_2018\_39603\_62520.jpg

Headwall and pipe visible on LS toe.

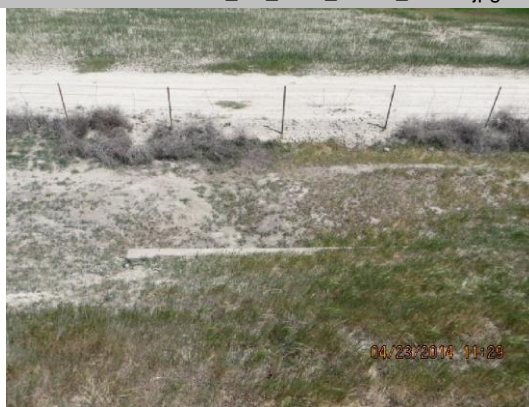
Photo 3 of 3 : UCIP\_SP\_2018\_34755\_62528.jpg

Headwall and pipe visible on LS toe.

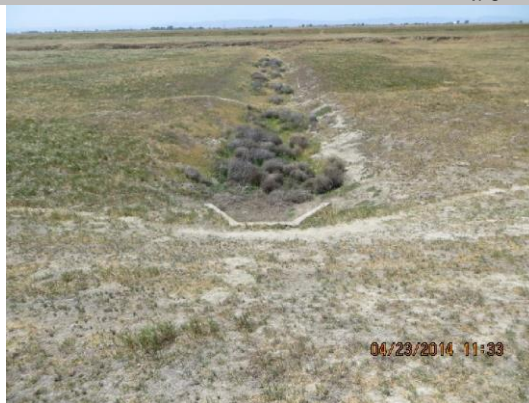
Photo 1 of 3 : UCIP\_SP\_2018\_34757\_62533.jpg

LM Start	20.10	Rating **	A/W	Issue No.	1359	
LM End	20.10	Issue Type +	Ma	Location *		
Category	Supplemental			GPS Latitude/Longitude		
				Start		End
Item	DWR UCIP LMA Responsibility			37.107091 °	37.107091 °	
				-120.553503 °	-120.553503 °	
DWR ID						
Comment Code						
Inspector Comment						
FS_ID:34757 DS_ID:19781 EP_NO: N/A Repair Type: No Action Needed Crossing Status: Found UCIP Comments: FIELD_STRUCT_DESC: 36-inch corrugated metal gravity drainage pipe through the levee, 9.9 feet below the crown. Flap gate on the waterside (WS) end. Concrete headwall on the landside (LS) end. Concrete U-shaped headwall on the WS end. [Additional Reference(s): DWR Levee Log, 2002. USACE San Joaquin O&M Manual 601.1, 1967, (HLM 20.05)]. FS Date: 4/23/2014

Headwall, pipe, and flapgate visible on WS toe.

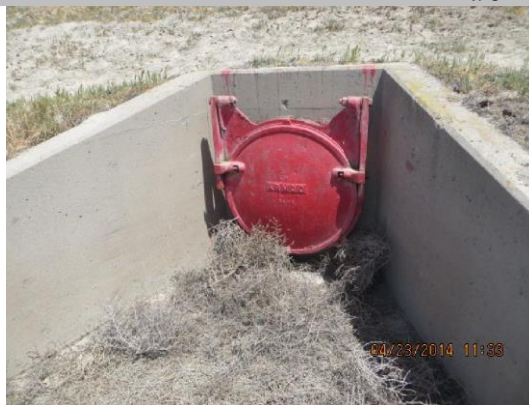
Photo 2 of 3 : UCIP\_SP\_2018\_34757\_62532.jpg

Headwall, pipe, and flapgate visible on WS toe.

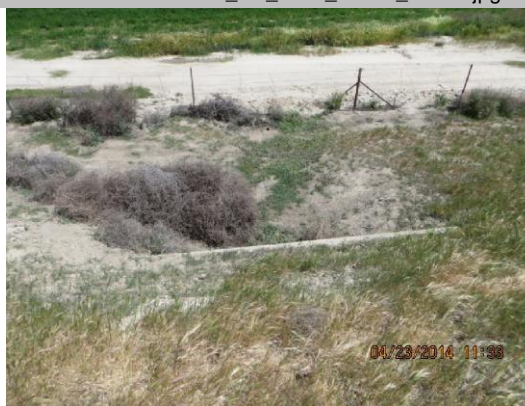
Photo 3 of 3 : UCIP\_SP\_2018\_34757\_62534.jpg

LM Start	20.10	Rating **	A/W	Issue No.	1359 (cont)	
LM End	20.10	Issue Type +	Ma	Location *		
Category	Supplemental			GPS Latitude/Longitude		
				Start	End	
Item	DWR UCIP LMA Responsibility			37.107091 °	37.107091 °	
				-120.553503 °	-120.553503 °	
DWR ID						
Comment Code						
Inspector Comment						
FS_ID:34757						
DS_ID:19781						
EP_NO: N/A						
Repair Type: No Action Needed						
Crossing Status: Found						
UCIP Comments:						
FIELD_STRUCT_DESC: 36-inch corrugated metal gravity drainage pipe through the levee, 9.9 feet below the crown. Flap gate on the waterside (WS) end. Concrete headwall on the landside (LS) end. Concrete U-shaped headwall on the WS end. [Additional Reference(s): DWR Levee Log, 2002. USACE San Joaquin O&M Manual 601.1, 1967, (HLM 20.05)].						
FS Date: 4/23/2014

Headwall and pipe visible on LS toe.

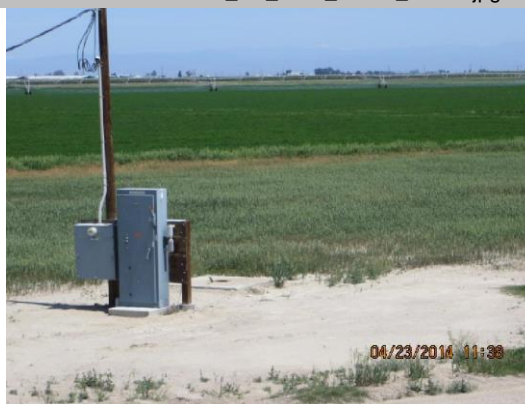
Photo 1 of 1 : UCIP\_SP\_2018\_34759\_62537.jpg

LM Start	20.19	Rating **	M	Issue No.	1360
LM End	20.19	Issue Type +	En	Location *	
Category	Supplemental			GPS Latitude/Longitude	
				Start	End
Item	DWR UCIP Field Study			37.106149 °	37.106149 °
				-120.552538 °	-120.552538 °
DWR ID					
Comment Code					
Inspector Comment					
FS_ID:34759 DS_ID:19782 EP_NO: 13828 Repair Type: Non-Urgent Crossing Status: Not Found UCIP Comments: FIELD_STRUCT_DESC: *DELETE* NOT INSTALLED THROUGH THE LEVEE. 24-inch steel irrigation pipe through the levee, 4.0 feet below the crown. Pump missing from pad on the landward side. Steel cutoff wall around pipe at center of levee. Siphon breaker on apex of pipe on landward shoulder. Pre-existing ditch runs from waterward toe to channel. Pipe extends from pump to the channel. Rock revetment on the cut slopes of the inlet channel. (Permit No. 13828-1988) FS Date: 4/23/2014

Well head visible off LS toe.

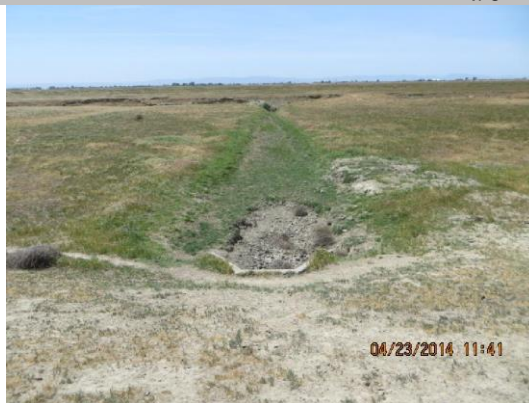
Photo 1 of 3 : UCIP\_SP\_2018\_34760\_62539.jpg

LM Start	20.24	Rating **	A/W	Issue No.	1361	
LM End	20.24	Issue Type +	Ma	Location *		
Category	Supplemental			GPS Latitude/Longitude		
				Start	End	
Item	DWR UCIP LMA Responsibility			37.105489 °	37.105489 °	
				-120.551886 °	-120.551886 °	
DWR ID						
Comment Code						
Inspector Comment						
FS_ID:34760						
DS_ID:19783						
EP_NO: N/A						
Repair Type: No Action Needed						
Crossing Status: Found						
UCIP Comments:						
FIELD_STRUCT_DESC: 36-inch corrugated metal gravity drainage pipe						
through the levee, 10.6 feet below the crown. Flap gate on the						
waterside (WS) end. Concrete headwall on each end. [Additional						
Reference(s): DWR Levee Log, 2002. USACE San Joaquin O&M						
Manual 601.1, 1967, (HLM 20.18)].						
FS Date: 4/23/2014

Headwall, pipe, and flapgate visible on WS toe.

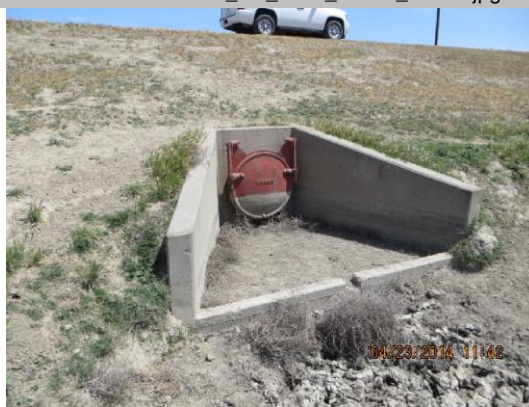
Photo 2 of 3 : UCIP\_SP\_2018\_34760\_62541.jpg

Headwall, pipe, and flapgate visible on WS toe.

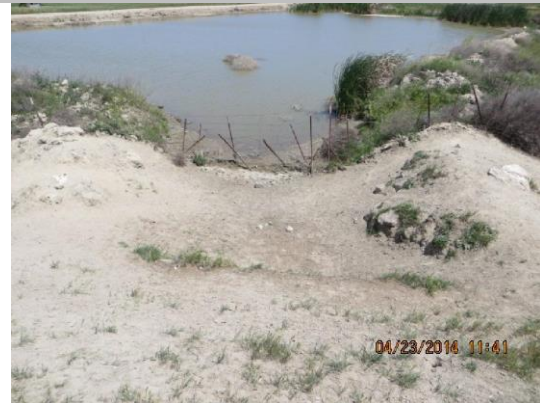
Photo 3 of 3 : UCIP\_SP\_2018\_34760\_62540.jpg

LM Start	20.24	Rating **	A/W	Issue No.	1361 (cont)	
LM End	20.24	Issue Type +	Ma	Location *		
Category	Supplemental			GPS Latitude/Longitude		
				Start	End	
Item	DWR UCIP LMA Responsibility			37.105489 °	37.105489 °	
				-120.551886 °	-120.551886 °	
DWR ID						
Comment Code						
Inspector Comment						
FS_ID:34760						
DS_ID:19783						
EP_NO: N/A						
Repair Type: No Action Needed						
Crossing Status: Found						
UCIP Comments:						
FIELD_STRUCT_DESC: 36-inch corrugated metal gravity drainage pipe						
through the levee, 10.6 feet below the crown. Flap gate on the						
waterside (WS) end. Concrete headwall on each end. [Additional						
Reference(s): DWR Levee Log, 2002. USACE San Joaquin O&M						
Manual 601.1, 1967, (HLM 20.18)].						
FS Date: 4/23/2014

Headwall and pipe visible on LS toe.

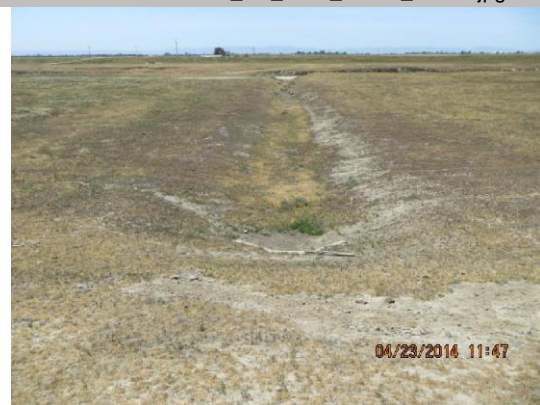
Photo 1 of 3 : UCIP\_SP\_2018\_39605\_62544.jpg

Comment Code					
Inspector Comment					
FS_ID:39605 DS_ID:19784 EP_NO: N/A Repair Type: Non-Urgent Crossing Status: Found UCIP Comments: Dense vegetation limits the inspector's visibility to identify signs of pipe failure (leaks) along the landward slope. Recommend removing vegetation along pipe alignment to conduct proper inspection of structure. FIELD_STRUCT_DESC: 24-inch corrugated metal gravity drainage pipe through the levee, 10.5 feet below the crown. Flap gate on the waterside (WS) end. Concrete headwall on the landside (LS) end. Concrete U-shaped headwall on the WS end. [Additional Reference(s): DWR Levee Log, 2002. USACE San Joaquin O&M Manual 601.1, 1967, (HLM 20.59)]. FS Date: 4/23/2014

Headwall, pipe, and flapgate visible on WS toe.

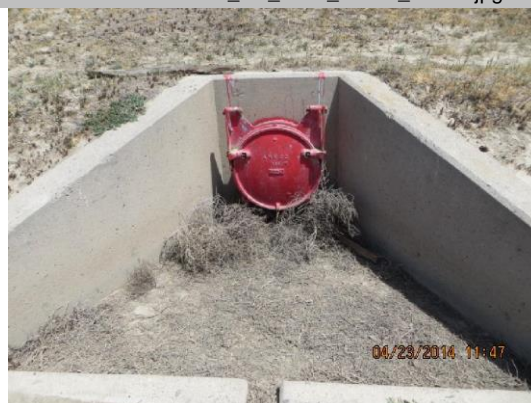
Photo 2 of 3 : UCIP\_SP\_2018\_39605\_62543.jpg

Comment Code					
Inspector Comment					
FS_ID:39605 DS_ID:19784 EP_NO: N/A Repair Type: Non-Urgent Crossing Status: Found UCIP Comments: Dense vegetation limits the inspector's visibility to identify signs of pipe failure (leaks) along the landward slope. Recommend removing vegetation along pipe alignment to conduct proper inspection of structure. FIELD_STRUCT_DESC: 24-inch corrugated metal gravity drainage pipe through the levee, 10.5 feet below the crown. Flap gate on the waterside (WS) end. Concrete headwall on the landside (LS) end. Concrete U-shaped headwall on the WS end. [Additional Reference(s): DWR Levee Log, 2002. USACE San Joaquin O&M Manual 601.1, 1967, (HLM 20.59)]. FS Date: 4/23/2014

Headwall, pipe, and flapgate visible on WS toe.

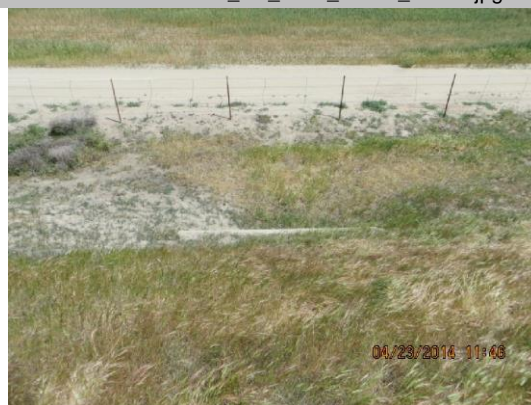
Photo 3 of 3 : UCIP\_SP\_2018\_39605\_62545.jpg

Headwall and pipe visible on LS toe.

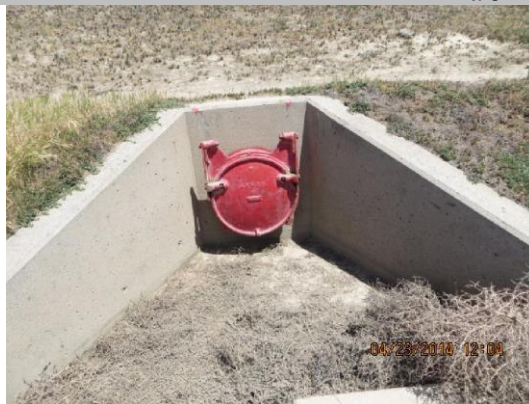
Photo 2 of 3 : UCIP\_SP\_2018\_39606\_62551.jpg

Headwall, pipe, and flapgate visible on WS toe.

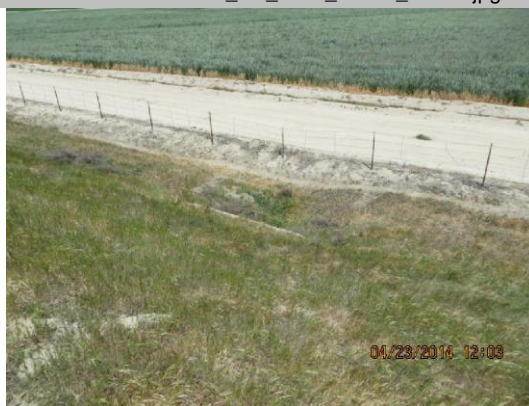
Photo 3 of 3 : UCIP\_SP\_2018\_39606\_62550.jpg

Item	DWR UCIP LMA Responsibility			37.095603 °	37.095603 °	
				-120.541593 °	-120.541593 °	
DWR ID						
Comment Code						
Inspector Comment						
FS_ID:39606 DS_ID:19785 EP_NO: N/A Repair Type: Non-Urgent Crossing Status: Found UCIP Comments: Dense vegetation limits the inspector's visibility to identify signs of pipe failure (leaks) along the landward slope. Recommend removing vegetation along pipe alignment to conduct proper inspection of structure. FIELD_STRUCT_DESC: 24-inch corrugated metal gravity drainage pipe through the levee, 11.8 feet below the crown. Flap gate on the waterside (WS) end. Concrete headwall on the landside (LS) end. Concrete U-shaped headwall on the WS end. [Additional Reference(s): DWR Levee Log, 2002. USACE San Joaquin O&M Manual 601.1, 1967, (HLM 21.08)]. FS Date: 4/23/2014

Headwall and pipe visible on LS toe.

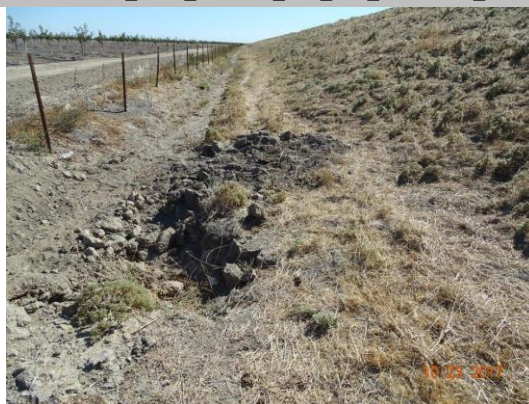
Photo 1 of 1 : SP\_2018\_NA0010\_123\_120\_20180307\_00025.jpg

LM Start	21.45	Rating **	M	Issue No.	120
LM End	21.45	Issue Type +	Ma	Location *	LS
Category	Earthen Levee			GPS Latitude/Longitude	
				Start	End
Item	Erosion / Bank Caving			37.092064 °	37.092064 °
				-120.537750 °	-120.537750 °
DWR ID	DWR_NA0010_05_f_2017_120				
Comment Code					
E2 : Schedule repair of erosion site prior to the next inspection.					
Inspector Comment					
Repair holes dug at the landside toe.

Looking southeast at the landside toe.

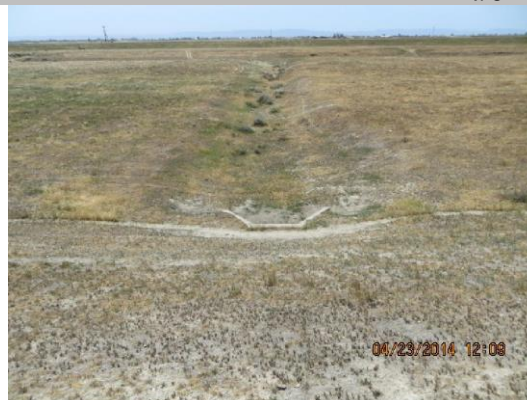
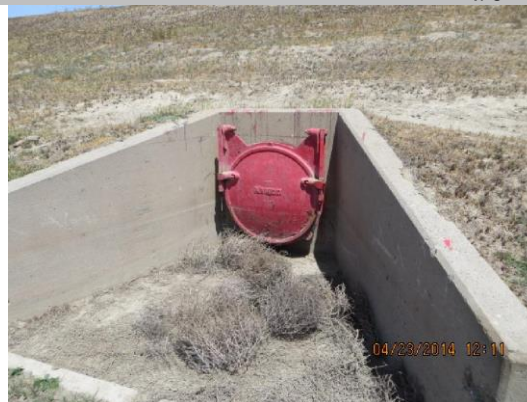
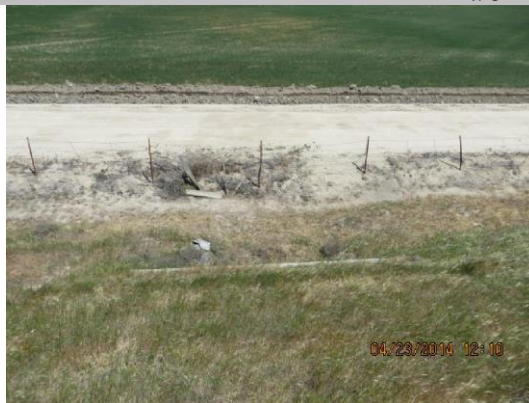
Comment Code					
Inspector Comment					
FS_ID:39614 DS_ID:19786 EP_NO: N/A Repair Type: Non-Urgent Crossing Status: Found UCIP Comments: Dense vegetation limits the inspector's visibility to identify signs of pipe failure (leaks) along the landward slope. Recommend removing vegetation along pipe alignment to conduct proper inspection of structure. FIELD_STRUCT_DESC: 36-inch corrugated metal gravity drainage pipe through the levee, 12.7 feet below the crown. Flap gate on the waterside (WS) end. Concrete headwall on the landside (LS) end. Concrete U-shaped headwall on the WS end. [Additional Reference(s): DWR Levee Log, 2002. USACE San Joaquin O&M Manual 601.1, 1967, (HLM 21.42)]. FS Date: 4/23/2014

Headwall, pipe, and flapgate visible on WS toe.

Headwall and pipe visible on LS toe.

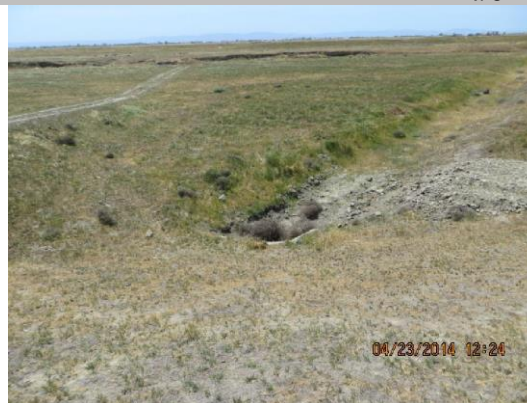
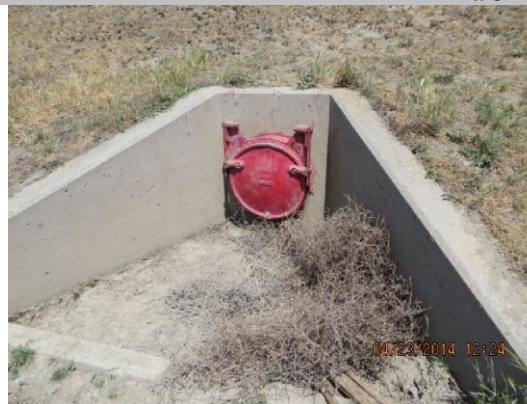
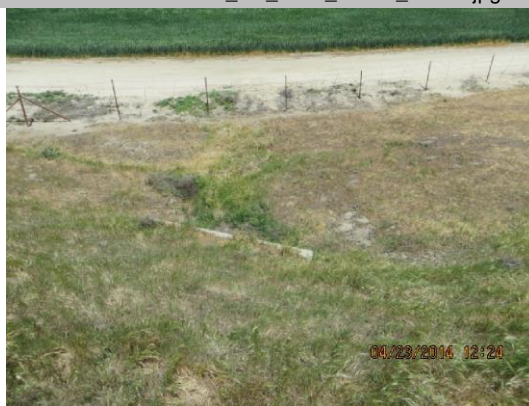
Comment Code					
Inspector Comment					
FS_ID:39883 DS_ID:19787 EP_NO: N/A Repair Type: Non-Urgent Crossing Status: Found UCIP Comments: Dense vegetation limits the inspector's visibility to identify signs of pipe failure (leaks) along the landward slope. Recommend removing vegetation along pipe alignment to conduct proper inspection of structure. FIELD_STRUCT_DESC: 24-inch corrugated metal gravity drainage pipe through the levee, 12.4 feet below the crown. Flap gate on the waterside (WS) end. Concrete headwall on the landside (LS) end. Concrete U-shaped headwall on the WS end. [Additional Reference(s): DWR Levee Log, 2002. USACE San Joaquin O&M Manual 601.1, 1967, (HLM 21.81)]. FS Date: 4/23/2014

Headwall, pipe, and flapgate visible on WS toe.

Headwall and pipe visible on LS toe.

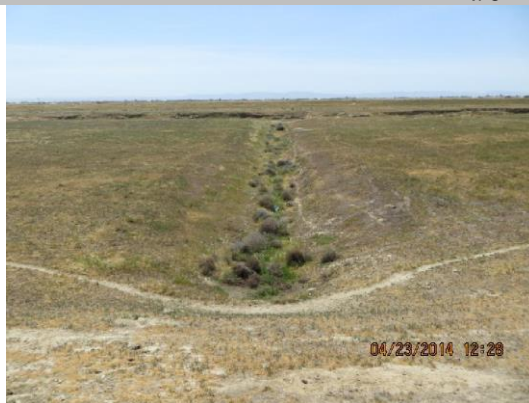
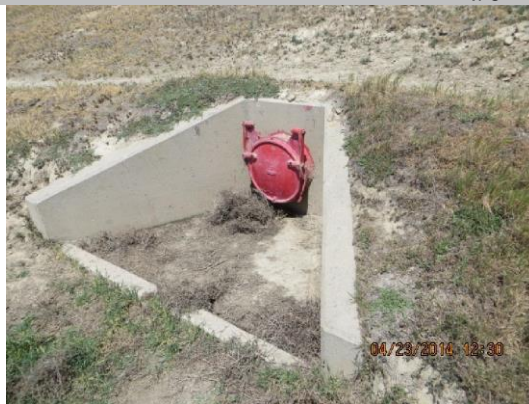
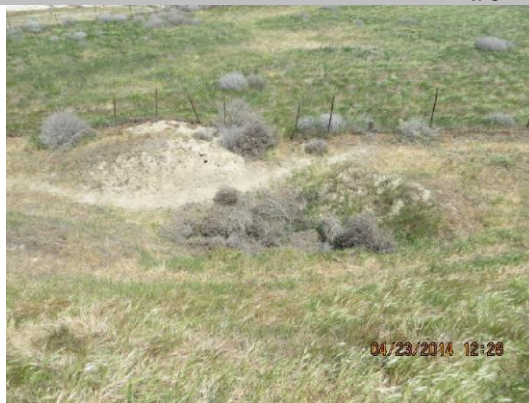
Comment Code					
Inspector Comment					
FS_ID:39610 DS_ID:19788 EP_NO: N/A Repair Type: Non-Urgent Crossing Status: Found UCIP Comments: Dense vegetation limits the inspector's visibility to identify signs of pipe failure (leaks) along the landward slope. Recommend removing vegetation along pipe alignment to conduct proper inspection of structure. FIELD_STRUCT_DESC: 24-inch corrugated metal gravity drainage pipe through the levee, 10.7 feet below the crown. Flap gate on the waterside (WS) end. Concrete headwall on the landside (LS) end. Concrete U-shaped headwall on the WS end. [Additional Reference(s): DWR Levee Log, 2002. USACE San Joaquin O&M Manual 601.1, 1967, (HLM 21.85)]. FS Date: 4/23/2014

Headwall, pipe, and flapgate visible on WS toe.

Headwall and pipe visible on LS toe.

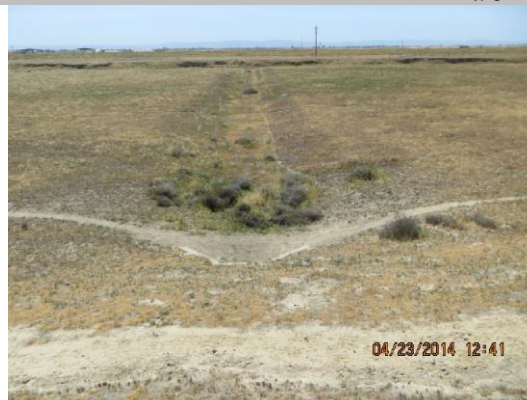
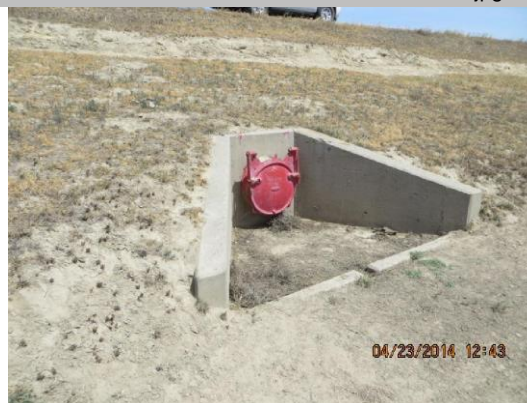
Comment Code					
Inspector Comment					
FS_ID:39611					
DS_ID:19789					
EP_NO: N/A					
Repair Type: Non-Urgent					
Crossing Status: Found					
UCIP Comments: Dense vegetation limits the inspector's visibility to identify signs of pipe failure (leaks) along the landward slope.					
Recommend removing vegetation along pipe alignment to conduct proper inspection of structure. Sediment buildup in pipe visible from landward side--recommend contacting owner to clear pipe.					
FIELD_STRUCT_DESC: 24-inch corrugated metal gravity drainage pipe through the levee, 10.2 feet below the crown. Flap gate on the waterside (WS) end. Concrete headwall on the landside (LS) end.					
Concrete U-shaped headwall on the WS end. [Additional Reference(s): DWR Levee Log, 2002. USACE San Joaquin O&M Manual 601.1, 1967, (HLM 22.19)].					
FS Date: 4/23/2014

Headwall, pipe, and flapgate visible on WS toe.

Headwall and pipe visible on LS toe.

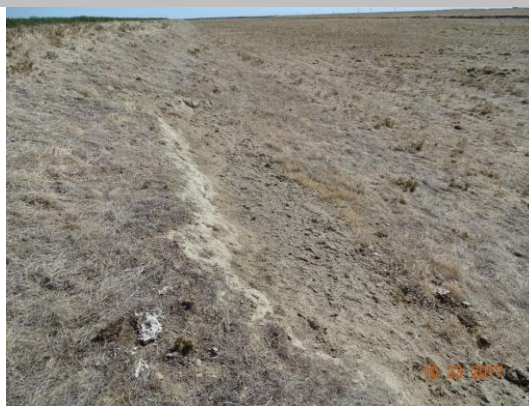
Photo 1 of 1 : SP\_2018\_NA0010\_123\_121\_20180307\_00026.jpg

LM Start	22.35	Rating **	M	Issue No.	121
LM End	22.35	Issue Type +	Ma	Location *	WS
Category	Earthen Levee			GPS Latitude/Longitude	
				Start	End
Item	Erosion / Bank Caving			37.082696 °	37.082696 °
				-120.527620 °	-120.527620 °
DWR ID	DWR_NA0010_05_f_2017_121				
Comment Code					
E1 : Note and monitor erosion site.					
Inspector Comment					
Waterside slope damaged by animal traffic.

Looking southeast at the waterside slope.

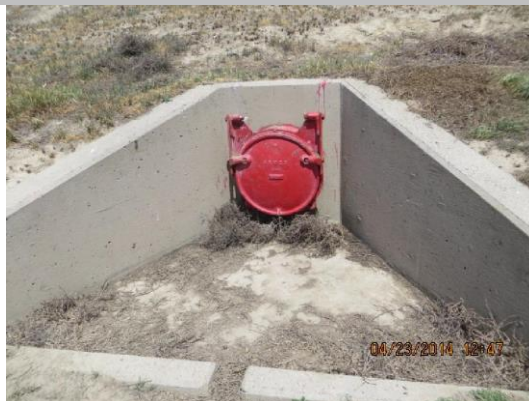
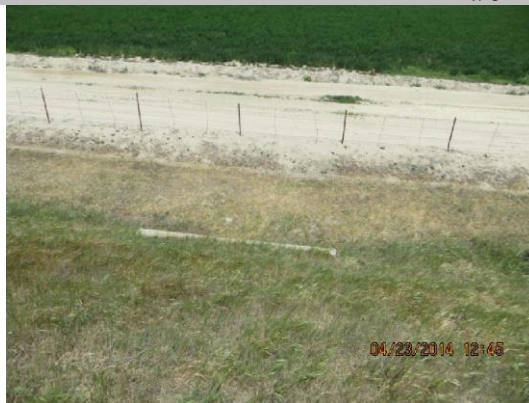
Comment Code						
Inspector Comment						
FS_ID:39613 DS_ID:19790 EP_NO: N/A Repair Type: Non-Urgent Crossing Status: Found UCIP Comments: Dense vegetation limits the inspector's visibility to identify signs of pipe failure (leaks) along the landward slope. Recommend removing vegetation along pipe alignment to conduct proper inspection of structure. Sediment buildup in pipe visible from landward side--recommend contacting owner to clear pipe. FIELD_STRUCT_DESC: 24-inch corrugated metal gravity drainage pipe through the levee, 10.4 feet below the crown. Flap gate on the waterside (WS) end. Concrete headwall on the landside (LS) end. Concrete U-shaped headwall on the WS end. [Additional Reference(s): DWR Levee Log, 2002. USACE San Joaquin O&M Manual 601.1, 1967, (HLM 22.79)]. FS Date: 4/23/2014

Headwall, pipe, and flapgate visible on WS toe.

Headwall and pipe visible on LS toe.

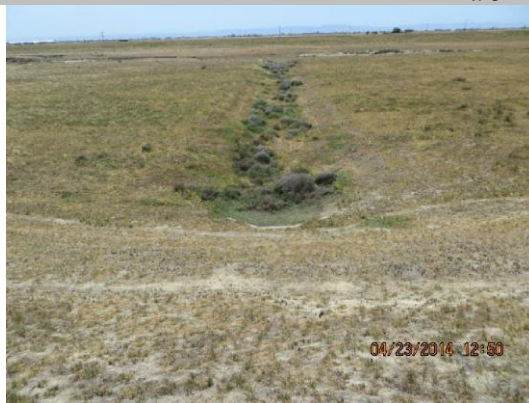
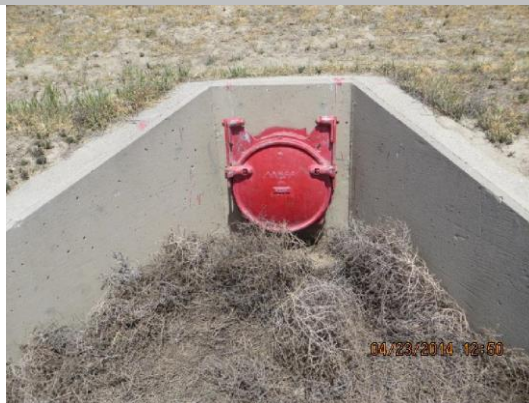
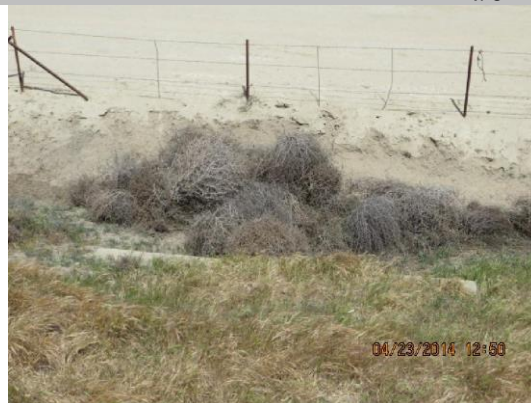
Comment Code						
Inspector Comment						
FS_ID:39616 DS_ID:19791 EP_NO: N/A Repair Type: Non-Urgent Crossing Status: Found UCIP Comments: Dense vegetation limits the inspector's visibility to identify signs of pipe failure (leaks) along the landward slope. Recommend removing vegetation along pipe alignment to conduct proper inspection of structure. Sediment buildup in pipe visible from landward side--recommend contacting owner to clear pipe. FIELD_STRUCT_DESC: 24-inch corrugated metal gravity drainage pipe through the levee, 12.2 feet below the crown. Flap gate on the waterside (WS) end. Concrete headwall on the landside (LS) end. Concrete U-shaped headwall on the WS end. [Additional Reference(s): DWR Levee Log, 2002. USACE San Joaquin O&M Manual 601.1, 1967, (HLM 22.94)]. FS Date: 4/23/2014

Headwall, pipe, and flapgate visible on WS toe.

Headwall and pipe visible on LS toe.

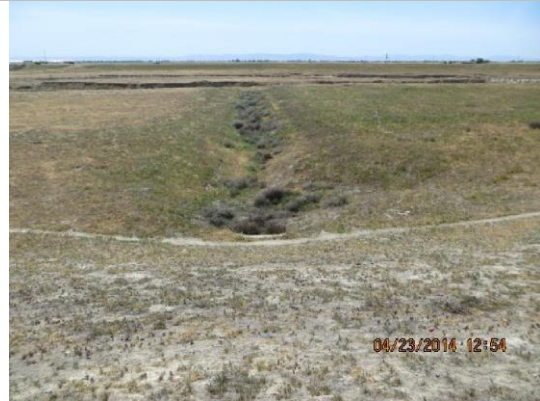
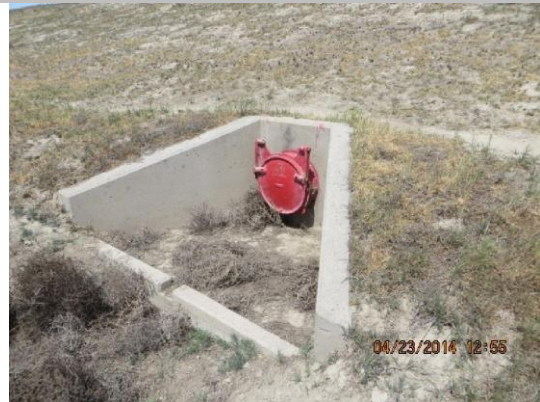
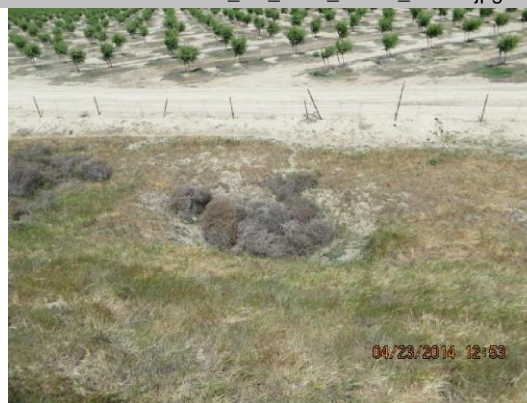
Comment Code						
Inspector Comment						
FS_ID:39617 DS_ID:19792 EP_NO: N/A Repair Type: Non-Urgent Crossing Status: Found UCIP Comments: Dense vegetation limits the inspector's visibility to identify signs of pipe failure (leaks) along the landward slope. Recommend removing vegetation along pipe alignment to conduct proper inspection of structure. FIELD_STRUCT_DESC: 24-inch corrugated metal gravity drainage pipe through the levee, 11.1 feet below the crown. Flap gate on the waterside (WS) end. Concrete headwall on the landside (LS) end. Concrete U-shaped headwall on the WS end. [Additional Reference(s): DWR Levee Log, 2002. USACE San Joaquin O&M Manual 601.1, 1967, (HLM 22.79)]. FS Date: 4/23/2014

Headwall, pipe, and flapgate visible on WS toe.

Headwall and pipe visible on LS toe.

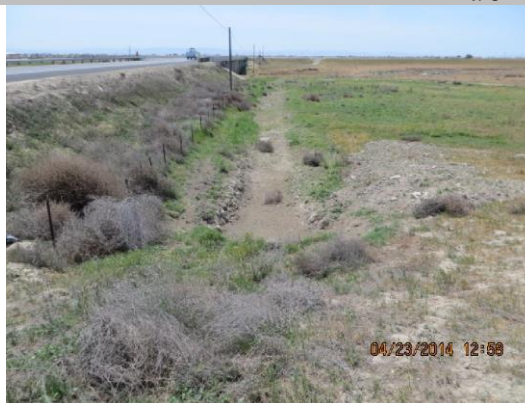
Photo 1 of 3 : UCIP\_SP\_2018\_39618\_62611.jpg

Comment Code					
Inspector Comment					
FS_ID:39618 DS_ID:19793 EP_NO: N/A Repair Type: Non-Urgent Crossing Status: Found UCIP Comments: Debris blocking closure of outlet. Dense vegetation limits the inspector's visibility to identify signs of pipe failure (leaks) along the waterward and landward slopes. Recommend removing vegetation along pipe alignment to conduct proper inspection of structure. FIELD_STRUCT_DESC: 24-inch corrugated metal gravity drainage pipe through the levee, 11.5 feet below the crown. Flap gate on the waterside (WS) end. Concrete headwall on the landside (LS) end. Concrete U-shaped headwall on the WS end. [Additional Reference(s): DWR Levee Log, 2002]. FS Date: 4/23/2014

Headwall, pipe, and flapgate visible on WS toe.

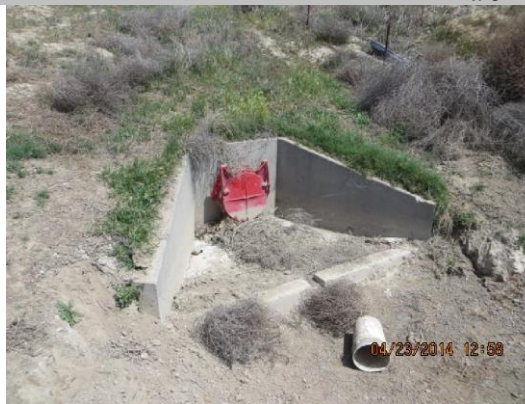
Photo 2 of 3 : UCIP\_SP\_2018\_39618\_62610.jpg

Headwall, pipe, and flapgate visible on WS toe.

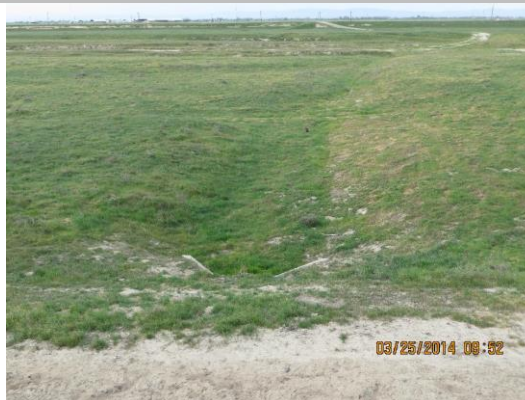
Photo 1 of 3 : UCIP\_SP\_2018\_32763\_59262.jpg

LM Start	23.25	Rating **	A/W	Issue No.	1372
LM End	23.25	Issue Type +	Ma	Location *	
Category	Supplemental			GPS Latitude/Longitude	
				Start	End
Item	DWR UCIP LMA Responsibility			37.072989 °	37.072989 °
				-120.516687 °	-120.516687 °
DWR ID					
Comment Code					
Inspector Comment					
FS_ID:32763 DS_ID:19794 EP_NO: N/A Repair Type: No Action Needed Crossing Status: Found UCIP Comments: FIELD_STRUCT_DESC: 30-inch corrugated metal gravity drainage pipe through the levee, 11.6 feet below the crown. Flap gate on the waterside (WS) end. Concrete headwall on the landside (LS) end. Concrete U-shaped headwall on the WS end. [Additional Reference(s): DWR Levee Log, 2002. USACE San Joaquin O&M Manual 601.1, 1967, (HLM 23.15)]. FS Date: 3/25/2014 9:04:45 AM

Concrete headwall on WS toe.

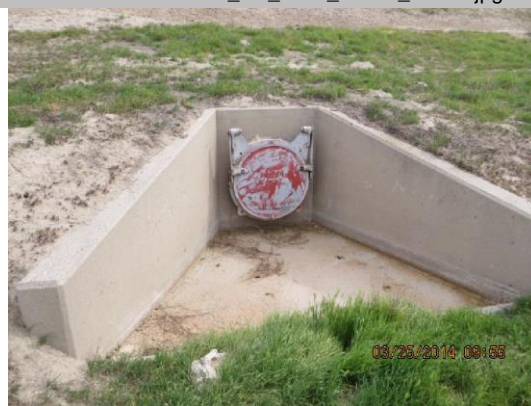
Photo 2 of 3 : UCIP\_SP\_2018\_32763\_59263.jpg

Flapgate and concrete headwall on WS toe.

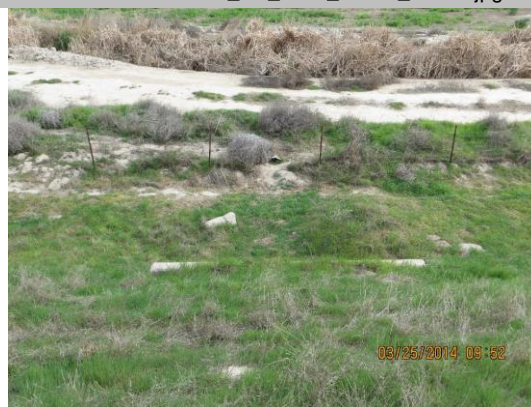
Photo 3 of 3 : UCIP\_SP\_2018\_32763\_59261.jpg

Concrete headwall on LS toe.
