**Flood Control Project Maintenance  
Levee Inspections**  
**LMA District Cover Sheet**  
**Spring 2018 Levee Inspection Results**

**Lower San Joaquin Levee District**

**Spring 2018 Levee Inspection Results**

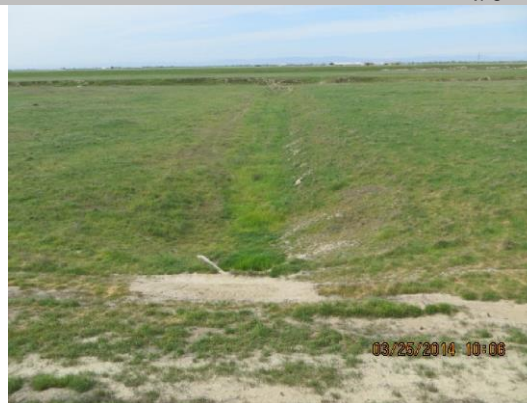
Photo 1 of 3 : UCIP\_SP\_2018\_39621\_59272.jpg

LM Start	23.72	Rating **	M	Issue No.	1373
LM End	23.72	Issue Type +	Ma	Location *	
Category	Supplemental			GPS Latitude/Longitude	
				Start	End
Item	DWR UCIP LMA Responsibility			37.067799 °	37.067799 °
				-120.511093 °	-120.511093 °
DWR ID					
Comment Code					
Inspector Comment					
FS_ID:39621 DS_ID:19796 EP_NO: N/A Repair Type: Non-Urgent Crossing Status: Found UCIP Comments: Sediment buildup in pipe visible from landward side--recommend contacting owner to clear pipe. FIELD_STRUCT_DESC: 30-inch corrugated metal gravity drainage pipe through the levee, 12.1 feet below the crown. Flap gate on the waterside (WS) end. Concrete U-shaped headwall on the WS end. [Additional Reference(s): DWR Levee Log, 2002. USACE San Joaquin O&M Manual 601.1, 1967, (HLM 23.62)]. FS Date: 3/25/2014

Concrete headwall on WS toe.

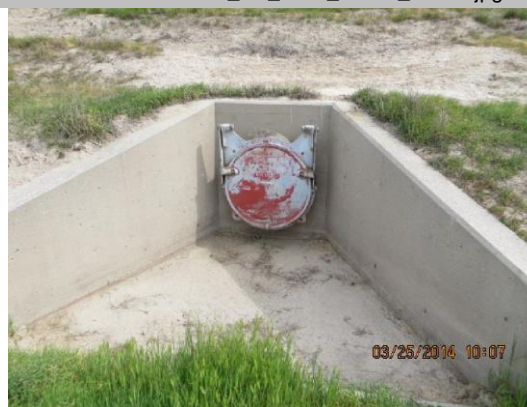
Photo 2 of 3 : UCIP\_SP\_2018\_39621\_59270.jpg

Flapgate on Concrete headwall on WS toe.

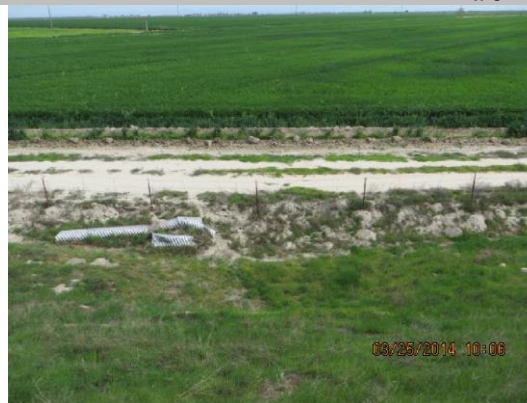
Photo 3 of 3 : UCIP\_SP\_2018\_39621\_59271.jpg

Concrete headwall on LS toe.

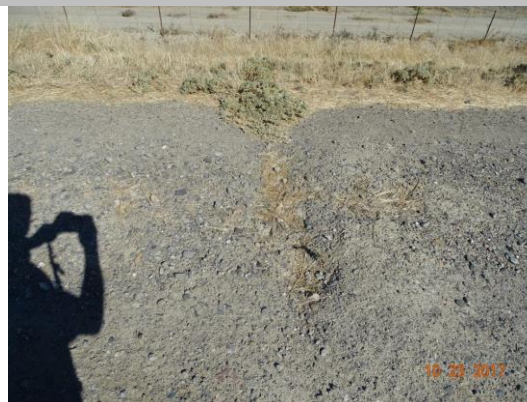
Photo 1 of 1 : SP\_2018\_NA0010\_123\_122\_20180307\_00027.jpg

LM Start	23.93	Rating **	M	Issue No.	122
LM End	24.77	Issue Type +	Ma	Location *	CR
Category	Earthen Levee			GPS Latitude/Longitude	
				Start	End
Item	Crown Surface / Depressions / Rutting			37.065492 °	37.056303 °
				-120.508587 °	-120.498637 °
DWR ID	DWR_NA0010_05_f_2017_122				
Comment Code					
C3 : Add appropriate gravel or road base. Grade and compact.					
Inspector Comment

Looking northeast at a representative pothole on the crown.

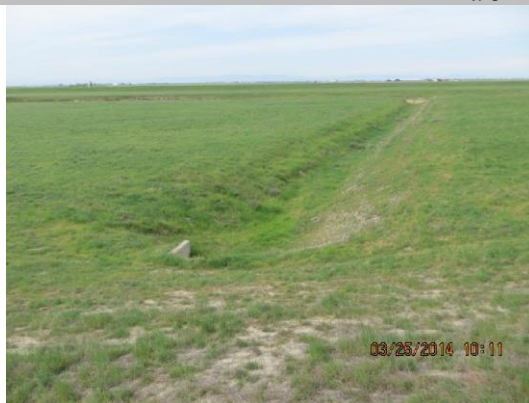
Photo 1 of 3 : UCIP\_SP\_2018\_39620\_59282.jpg

LM Start	24.02	Rating **	M	Issue No.	1374
LM End	24.02	Issue Type +	Ma	Location *	
Category	Supplemental			GPS Latitude/Longitude	
				Start	End
Item	DWR UCIP LMA Responsibility			37.064494 °	37.064494 °
				-120.507531 °	-120.507531 °
DWR ID					
Comment Code					
Inspector Comment					
FS_ID:39620 DS_ID:19797 EP_NO: N/A Repair Type: Non-Urgent Crossing Status: Found UCIP Comments: Minor sediment/debris buildup in pipe visible from landward side--recommend contacting owner to clear pipe. FIELD_STRUCT_DESC: 36-inch corrugated metal gravity drainage pipe through the levee, 12.1 feet below the crown. Flap gate on the waterside (WS) end. Concrete headwall on the landside (LS) end. Concrete U-shaped headwall on the WS end. [Additional Reference(s): DWR Levee Log, 2002. USACE San Joaquin O&M Manual 601.1, 1967, (HLM 23.85)]. FS Date: 3/25/2014

Concrete headwall on WS toe.

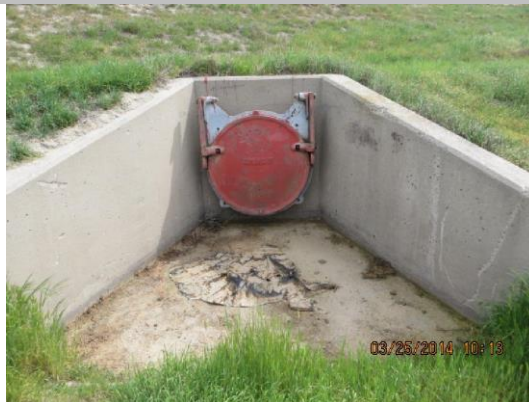
Photo 2 of 3 : UCIP\_SP\_2018\_39620\_59280.jpg

Flapgate at Concrete headwall on WS toe.

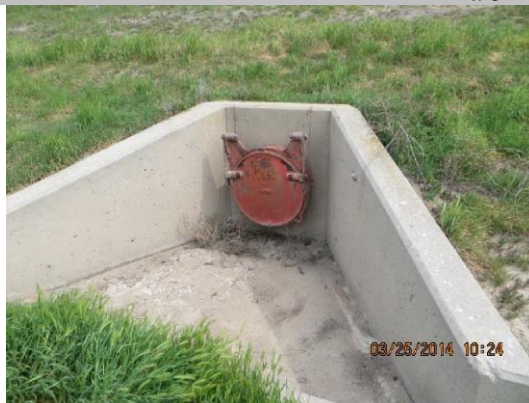
Photo 2 of 3 : UCIP\_SP\_2018\_46850\_59285.jpg

Item	DWR UCIP LMA Responsibility			37.061724 °	37.061724 °	
				-120.504512 °	-120.504512 °	
DWR ID						
Comment Code						
Inspector Comment						
FS_ID:46850 DS_ID:19798 EP_NO: N/A Repair Type: Non-Urgent Crossing Status: Found UCIP Comments: Dense vegetation limits the inspector's visibility to identify signs of pipe failure (leaks) along the landward slope. Recommend removing vegetation along pipe alignment to conduct proper inspection of structure. FIELD_STRUCT_DESC: 24-inch corrugated metal gravity drainage pipe through the levee, 11.2 feet below the crown. Flap gate on the waterside (WS) end. Concrete headwall on the landside (LS) end. Concrete U-shaped headwall on the WS end. [Additional Reference(s): DWR Levee Log, 2002. USACE San Joaquin O&M Manual 601.1, 1967, (HLM 24.18)]. FS Date: 3/25/2014

Flapgate at concrete headwall at WS toe.

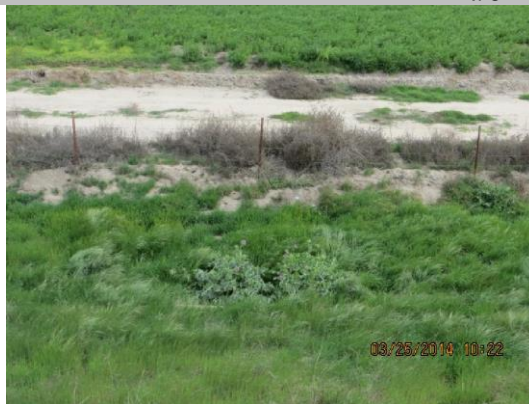
Photo 3 of 3 : UCIP\_SP\_2018\_46850\_59286.jpg

Concrete headwall at LS toe.

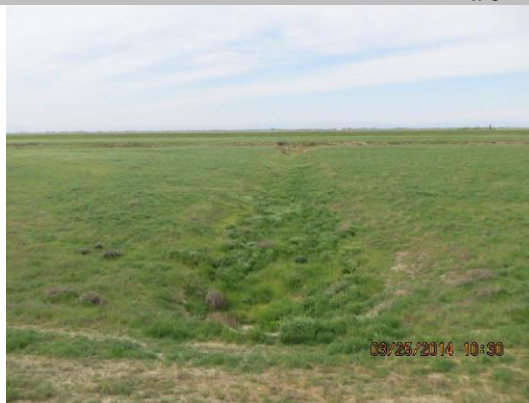
Photo 1 of 3 : UCIP\_SP\_2018\_39623\_59292.jpg

Comment Code					
Inspector Comment					
FS_ID:39623 DS_ID:19799 EP_NO: N/A Repair Type: Non-Urgent Crossing Status: Found UCIP Comments: Dense vegetation limits the inspector's visibility to identify signs of pipe failure (leaks) along the landward slope. Recommend removing vegetation along pipe alignment to conduct proper inspection of structure. FIELD_STRUCT_DESC: 24-inch corrugated metal gravity drainage pipe through the levee, 11.2 feet below the crown. Flap gate on the waterside (WS) end. Concrete headwall on the landside (LS) end. Concrete U-shaped headwall on the WS end. [Additional Reference(s): DWR Levee Log, 2002. USACE San Joaquin O&M Manual 601.1, 1967, (HLM 24.46)]. FS Date: 3/25/2014

Concrete headwall on WS toe.

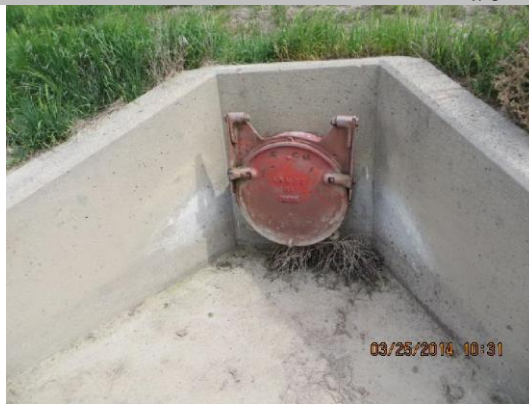
Photo 2 of 3 : UCIP\_SP\_2018\_39623\_59290.jpg

Flapgate at Concrete headwall on WS toe.

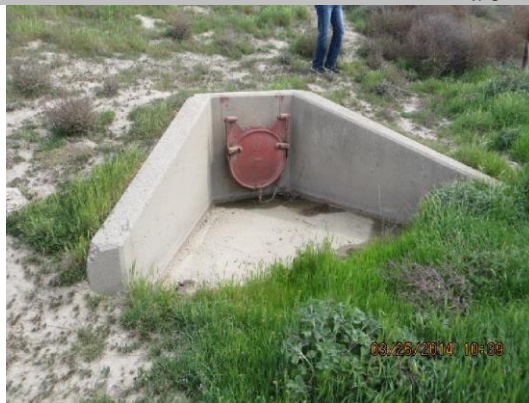
Photo 2 of 3 : UCIP\_SP\_2018\_32786\_59295.jpg

LM Start	24.93	Rating **	A/W	Issue No.	1377 (cont)	
LM End	24.93	Issue Type +	Ma	Location *		
Category	Supplemental			GPS Latitude/Longitude		
				Start		End
Item	DWR UCIP LMA Responsibility			37.054481 °		37.054481 °
				-120.496798 °		-120.496798 °
DWR ID						
Comment Code						
Inspector Comment						
FS_ID:32786 DS_ID:19800 EP_NO: N/A Repair Type: No Action Needed Crossing Status: Found UCIP Comments: FIELD_STRUCT_DESC: 24-inch corrugated metal gravity drainage pipe through the levee, 10.7 feet below the crown. Flap gate on the waterside (WS) end. Concrete headwall on the landside (LS) end. Concrete U-shaped headwall on the WS end. [Additional Reference(s): DWR Levee Log, 2002. USACE San Joaquin O&M Manual 601.1, 1967, (HLM 24.82)]. FS Date: 3/25/2014

Flapgate on concrete headwall on WS toe.

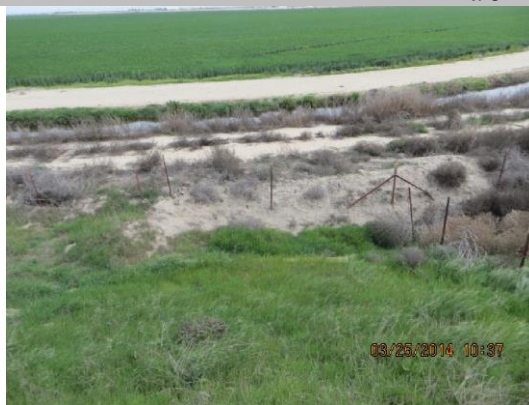
Photo 3 of 3 : UCIP\_SP\_2018\_32786\_59296.jpg

Concrete headwall on LS toe.

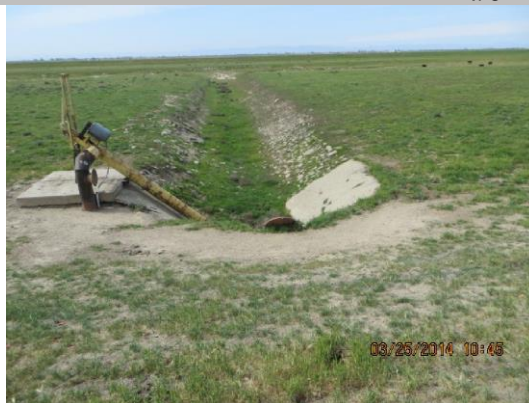
Photo 1 of 3 : UCIP\_SP\_2018\_39624\_59302.jpg

LM Start	24.96	Rating **	A/W	Issue No.	1378
LM End	24.96	Issue Type +	Ma	Location *	
Category	Supplemental			GPS Latitude/Longitude	
				Start	End
Item	DWR UCIP LMA Responsibility			37.054344 °	37.054344 °
				-120.496214 °	-120.496214 °
DWR ID					
Comment Code					
Inspector Comment					
FS_ID:39624 DS_ID:19801 EP_NO: N/A Repair Type: No Action Needed Crossing Status: Found UCIP Comments: FIELD_STRUCT_DESC: 30-inch corrugated metal gravity drainage pipe through the levee, 10.9 feet below the crown. Flap gate on the waterside (WS) end. Concrete headwall on the landside (LS) end. Concrete U-shaped headwall on the WS end. [Additional Reference(s): DWR Levee Log, 2002. USACE San Joaquin O&M Manual 601.1, 1967, (HLM 24.87)]. FS Date: 3/25/2014

Flapgate and channel off WS toe.

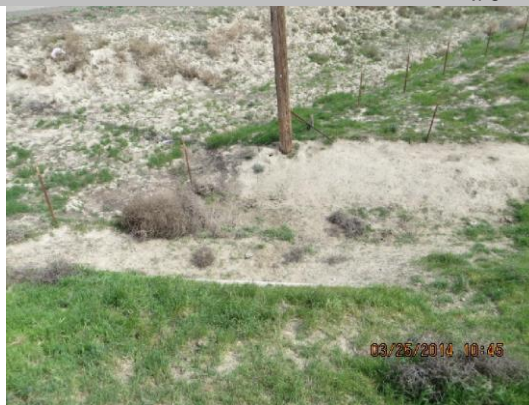
Photo 2 of 3 : UCIP\_SP\_2018\_39624\_59301.jpg

Concrete headwall on LS toe.

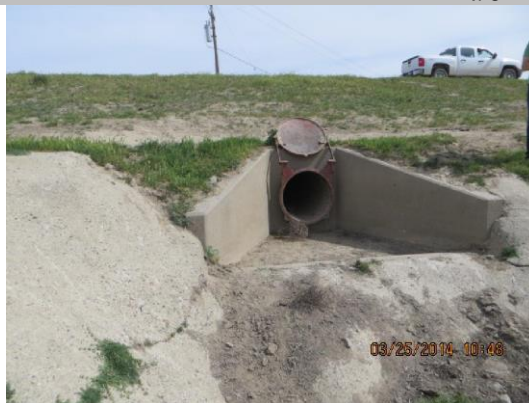
Photo 3 of 3 : UCIP\_SP\_2018\_39624\_59303.jpg

Flapgate on headwall at WS toe.

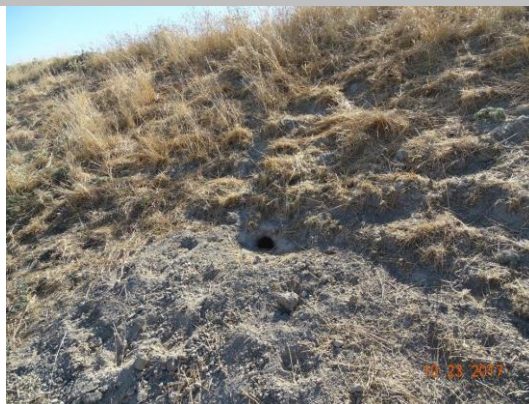
Photo 1 of 1 : SP\_2018\_NA0010\_123\_123\_20180307\_00028.jpg

LM Start	24.98	Rating **	M	Issue No.	123
LM End	25.26	Issue Type +	Ma	Location *	LS
Category	Earthen Levee			GPS Latitude/Longitude	
				Start	End
Item	Animal Control			37.054150 °	37.051252 °
				-120.495964 °	-120.492368 °
DWR ID	DWR_NA0010_05_f_2017_123				
Comment Code					
A3 : No rodents visible, but rodent burrows visible; need to backfill and compact or grout burrows.					
Inspector Comment

Looking southwest at the landside slope.

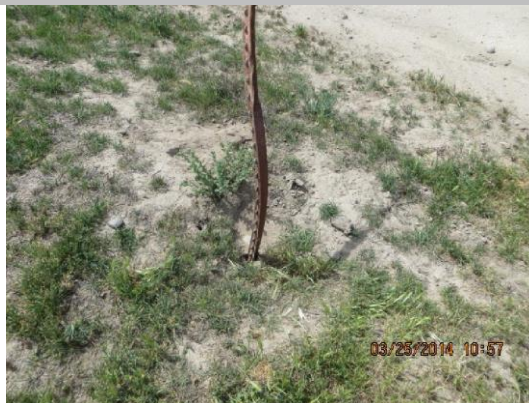
Photo 2 of 3 : UCIP\_SP\_2018\_41716\_59307.jpg

Buried Siphon breaker on WS shoulder.

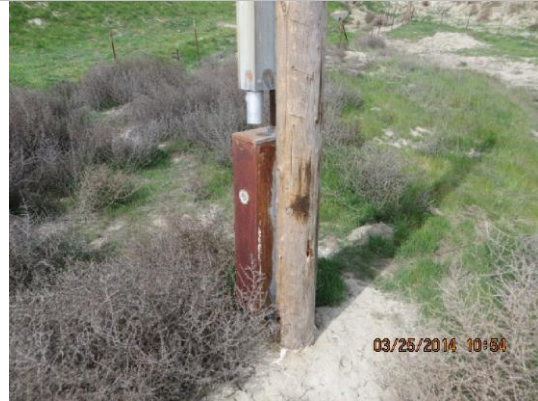
Photo 3 of 3 : UCIP\_SP\_2018\_41716\_59304.jpg

Power pole, meter, and electrical panel off LS toe.

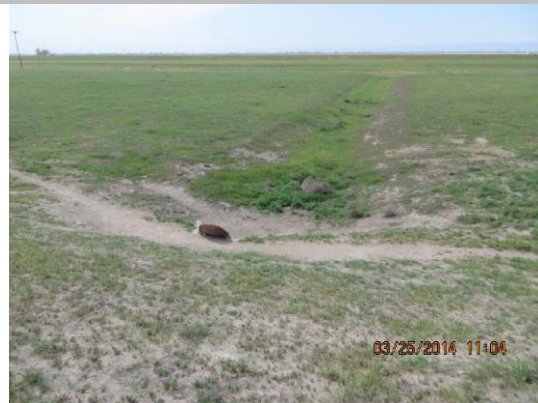
Photo 1 of 3 : UCIP\_SP\_2018\_32789\_59311.jpg

LM Start	25.24	Rating **	M	Issue No.	1380
LM End	25.24	Issue Type +	Ma	Location *	
Category	Supplemental			GPS Latitude/Longitude	
				Start	End
Item	DWR UCIP LMA Responsibility			37.051477 °	37.051477 °
				-120.492650 °	-120.492650 °
DWR ID					
Comment Code					
Inspector Comment					
FS_ID:32789 DS_ID:19803 EP_NO: N/A Repair Type: Non-Urgent Crossing Status: Found UCIP Comments: Flapgate propped open during flood season. FIELD_STRUCT_DESC: 30-inch corrugated metal gravity drainage pipe through the levee, 11.3 feet below the crown. Flap gate on the waterside (WS) end. Concrete headwall on the landside (LS) end. Concrete U-shaped headwall on the WS end. [Additional Reference(s): DWR Levee Log, 2002. USACE San Joaquin O&M Manual 601.1, 1967, (HLM 25.13)]. FS Date: 3/25/2014

Concrete headwall and flapgate on WS toe.

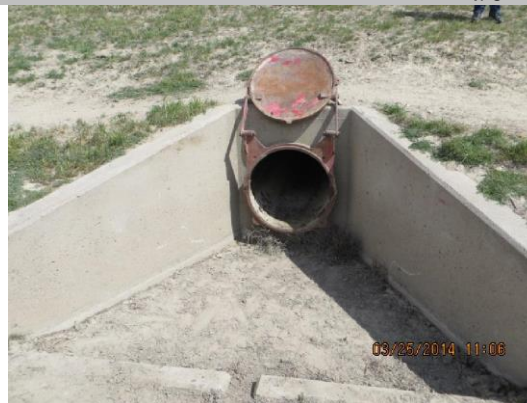
Photo 2 of 3 : UCIP\_SP\_2018\_32789\_59312.jpg

Concrete headwall and flapgate on WS toe.

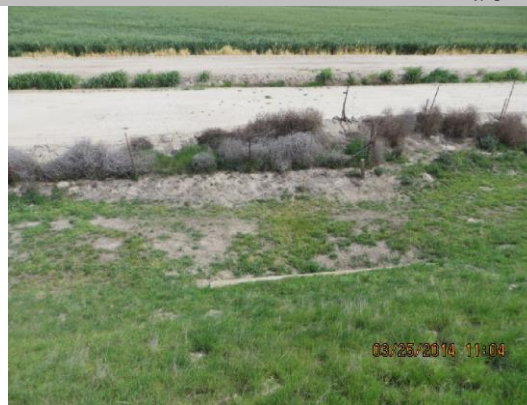
Photo 3 of 3 : UCIP\_SP\_2018\_32789\_59310.jpg

Concrete headwall on LS toe.

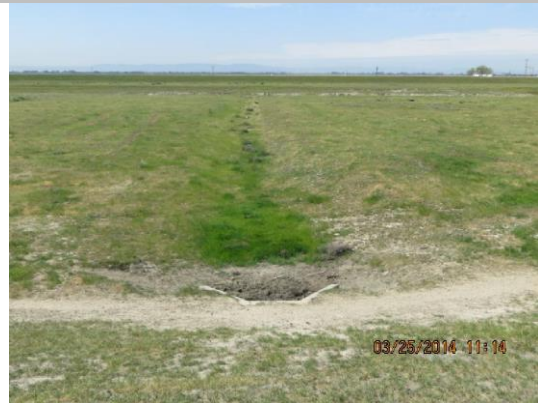
Photo 1 of 3 : UCIP\_SP\_2018\_39625\_59316.jpg

Comment Code						
Inspector Comment						
FS_ID:39625 DS_ID:19804 EP_NO: N/A Repair Type: Non-Urgent Crossing Status: Found UCIP Comments: Dense vegetation limits the inspector's visibility to identify signs of pipe failure (leaks) along the landward slope. Recommend removing vegetation along pipe alignment to conduct proper inspection of structure. Sediment buildup in pipe visible from landward side--recommend contacting owner to clear pipe. FIELD_STRUCT_DESC: 30-inch corrugated metal gravity drainage pipe through the levee, 12 feet below the crown. Flap gate on the waterside (WS) end. Concrete headwall on the landside (LS) end. Concrete U-shaped headwall on the WS end. [Additional Reference(s): DWR Levee Log, 2002. USACE San Joaquin O&M Manual 601.1, 1967, (HLM 25.51)]. FS Date: 3/25/2014

Concrete headwall on WS toe.

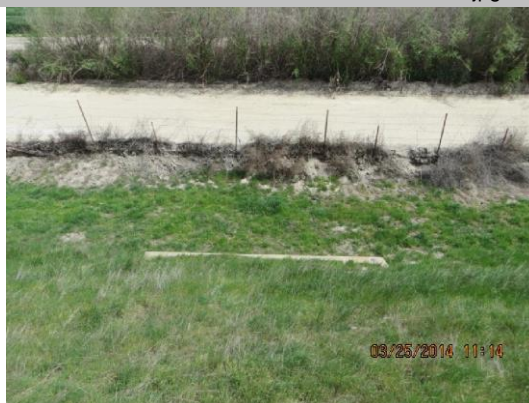
Photo 3 of 3 : UCIP\_SP\_2018\_39625\_59315.jpg

Concrete headwall on LS toe.

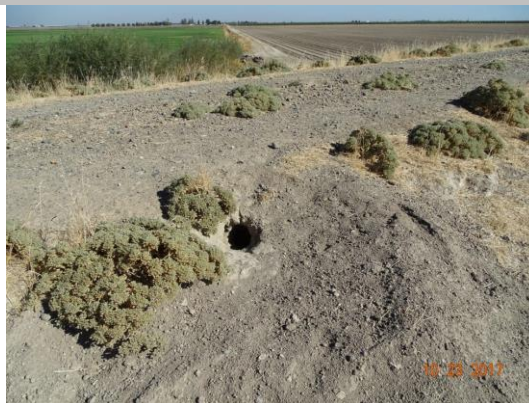
Photo 1 of 1 : SP\_2018\_NA0010\_123\_124\_20180307\_00029.jpg

LM Start	25.61	Rating **	U	Issue No.	124
LM End	25.61	Issue Type +	Ma	Location *	WS
Category	Earthen Levee			GPS Latitude/Longitude	
				Start	End
Item	Animal Control			37.047416 °	37.047416 °
				-120.488411 °	-120.488411 °
DWR ID	DWR_NA0010_05_f_2017_124				
Comment Code					
A3 : No rodents visible, but rodent burrows visible; need to backfill and compact or grout burrows.					
Inspector Comment

Looking east at the waterside slope.

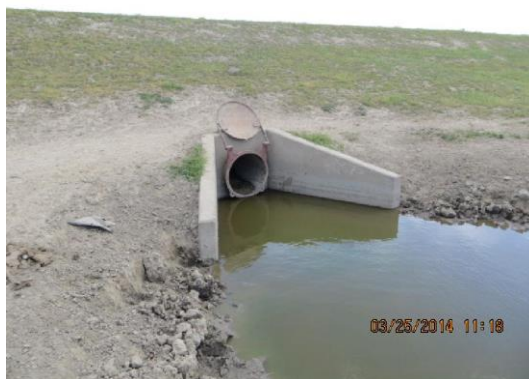
Photo 1 of 3 : UCIP\_SP\_2018\_39626\_59321.jpg

LM Start	25.63	Rating **	M	Issue No.	1382
LM End	25.63	Issue Type +	Ma	Location *	
Category	Supplemental			GPS Latitude/Longitude	
				Start	End
Item	DWR UCIP LMA Responsibility			37.047170 °	37.047170 °
				-120.488222 °	-120.488222 °
DWR ID					
Comment Code					
Inspector Comment					
FS_ID:39626 DS_ID:19805 EP_NO: N/A Repair Type: Non-Urgent Crossing Status: Found UCIP Comments: Sediment buildup in pipe visible from landward side-- recommend contacting owner to clear pipe. FIELD_STRUCT_DESC: 30-inch corrugated metal gravity drainage pipe through the levee, 12.1 feet below the crown. Flap gate on the waterside (WS) end. Concrete headwall on the landside (LS) end. Concrete U-shaped headwall on the WS end. [Additional Reference(s): DWR Levee Log, 2002. USACE San Joaquin O&M Manual 601.1, 1967, (HLM 25.53)]. FS Date: 3/25/2014

Flapgate on headwall at WS toe.

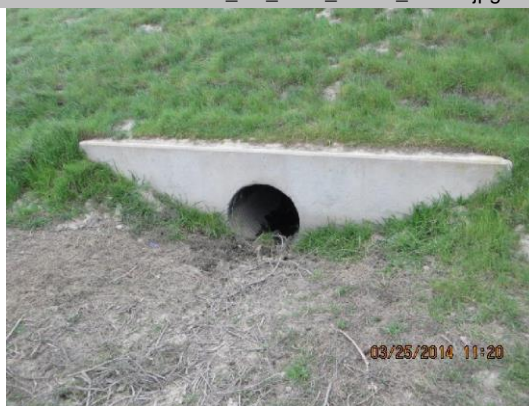
Photo 2 of 3 : UCIP\_SP\_2018\_39626\_59320.jpg

Concrete headwall on LS toe.

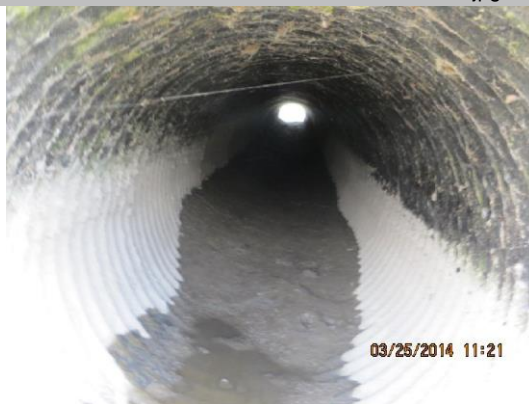
Photo 3 of 3 : UCIP\_SP\_2018\_39626\_59319.jpg

Inside pipe on LS toe.

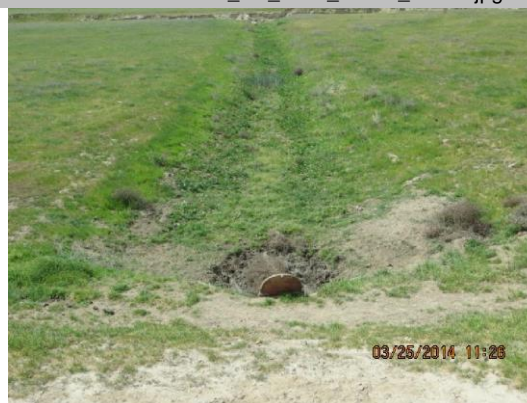
Photo 1 of 3 : UCIP\_SP\_2018\_39627\_59341.jpg

LM Start	26.20	Rating **	M	Issue No.	1383	
LM End	26.20	Issue Type +	Ma	Location *		
Category	Supplemental			GPS Latitude/Longitude		
				Start		End
Item	DWR UCIP LMA Responsibility			37.040070 °		37.040070 °
				-120.482796 °		-120.482796 °
DWR ID						
Comment Code						
Inspector Comment						
FS_ID:39627 DS_ID:19806 EP_NO: N/A Repair Type: Non-Urgent Crossing Status: Found UCIP Comments: Sediment buildup in pipe visible from landward side--recommend contacting owner to clear pipe. FIELD_STRUCT_DESC: 24-inch corrugated metal gravity drainage pipe through the levee, 10 feet below the crown. Flap gate on the waterside (WS) end. Concrete headwall on the landside (LS) end. Concrete U-shaped headwall on the WS end. [Additional Reference(s): DWR Levee Log, 2002. USACE San Joaquin O&M Manual 601.1, 1967, (HLM 26.11)]. FS Date: 3/25/2014

Concrete headwall on WS toe.

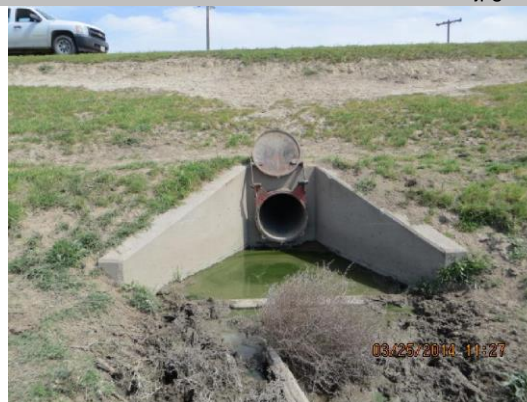
Photo 2 of 3 : UCIP\_SP\_2018\_39627\_59340.jpg

Flapgate on Concrete headwall at WS toe.

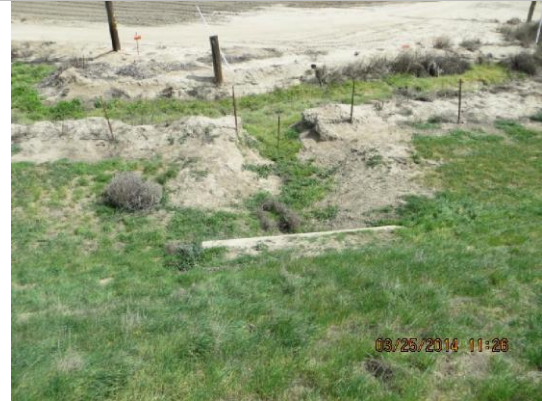
Photo 3 of 3 : UCIP\_SP\_2018\_39627\_59342.jpg

Concrete headwall on LS toe.

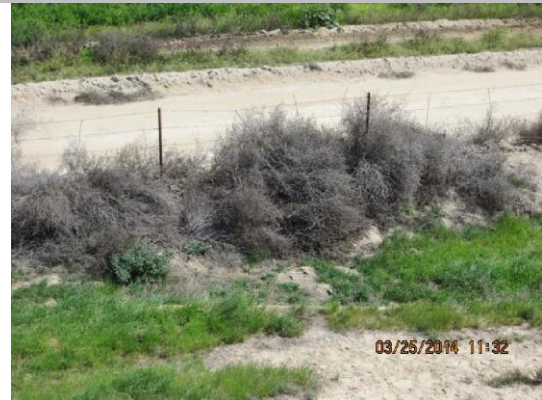
Photo 1 of 3 : UCIP\_SP\_2018\_32804\_59347.jpg

LM Start	26.39	Rating **	A/W	Issue No.	1384
LM End	26.39	Issue Type +	Ma	Location *	
Category	Supplemental			GPS Latitude/Longitude	
				Start	End
Item	DWR UCIP LMA Responsibility			37.037772 °	37.037772 °
				-120.481028 °	-120.481028 °
DWR ID					
Comment Code					
Inspector Comment					
FS_ID:32804 DS_ID:19807 EP_NO: N/A Repair Type: No Action Needed Crossing Status: Found UCIP Comments: FIELD_STRUCT_DESC: 36-inch corrugated metal gravity drainage pipe through the levee, 13 feet below the crown. Flap gate on the waterside (WS) end. Concrete headwall on the landside (LS) end. Concrete U-shaped headwall on the WS end. [Additional Reference(s): DWR Levee Log, 2002. USACE San Joaquin O&M Manual 601.1, 1967, (HLM 26.29)]. FS Date: 3/25/2014

Concrete headwall on LS toe.

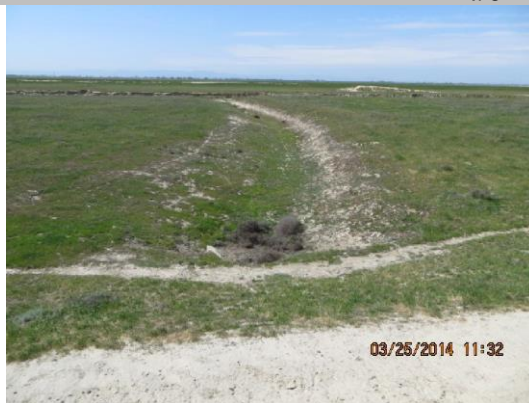
Photo 2 of 3 : UCIP\_SP\_2018\_32804\_59346.jpg

Concrete headwall on WS toe.

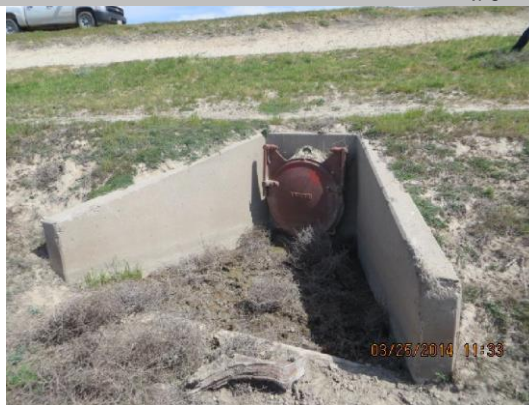
Photo 3 of 3 : UCIP\_SP\_2018\_32804\_59345.jpg

Flapgate on Concrete headwall at WS toe.

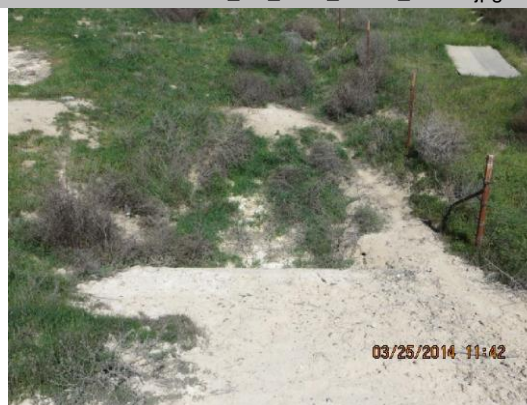
Photo 1 of 3 : UCIP\_SP\_2018\_39628\_59350.jpg

LM Start	26.95	Rating **	M	Issue No.	1385
LM End	26.95	Issue Type +	Ma	Location *	
Category	Supplemental			GPS Latitude/Longitude	
				Start	End
Item	DWR UCIP LMA Responsibility			37.032669 °	37.032669 °
				-120.473901 °	-120.473901 °
DWR ID					
Comment Code					
Inspector Comment					
FS_ID:39628 DS_ID:19808 EP_NO: N/A Repair Type: Non-Urgent Crossing Status: Found UCIP Comments: Pipe has heavy silt buildup visible from landward side--recommend contacting owner to clear pipe. FIELD_STRUCT_DESC: 24-inch corrugated metal gravity drainage pipe through the levee, 11.4 feet below the crown. Flap gate on the waterside (WS) end. Concrete headwall on the landside (LS) end. Concrete U-shaped headwall on the WS end. [Additional Reference(s): DWR Levee Log, 2002. USACE San Joaquin O&M Manual 601.1, 1967, (HLM 26.85)]. FS Date: 3/25/2014

Concrete headwall on LS toe.

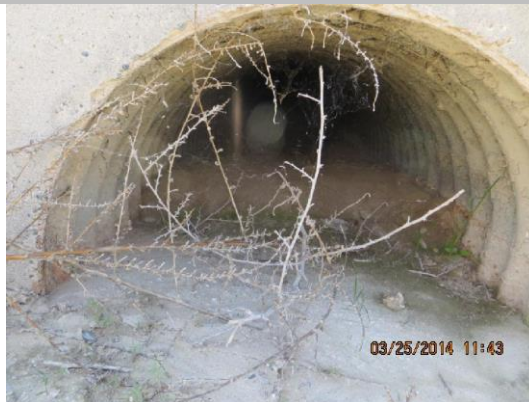
Photo 3 of 3 : UCIP\_SP\_2018\_39628\_59348.jpg

Silt buildup in pipe at LS toe.

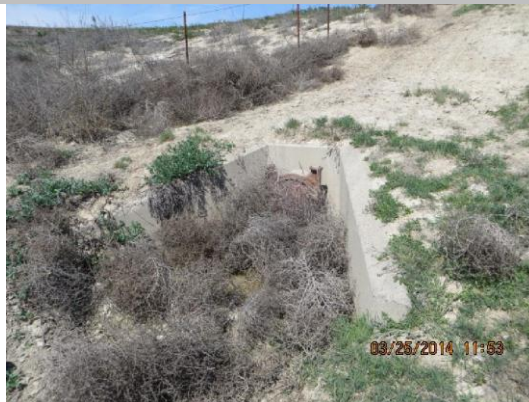
Photo 2 of 3 : UCIP\_SP\_2018\_32806\_59355.jpg

Flapgate and Concrete headwall at WS toe.

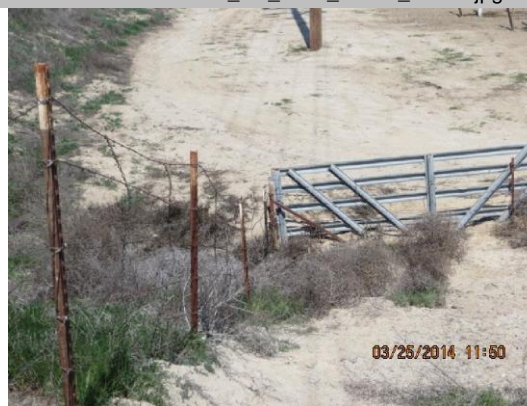
Photo 3 of 3 : UCIP\_SP\_2018\_32806\_59354.jpg

Concrete headwall at LS toe.

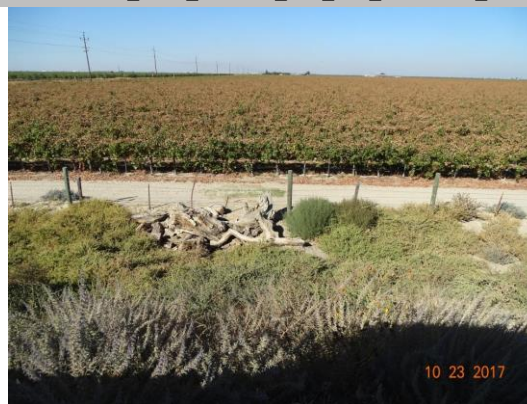
Photo 1 of 1 : SP\_2018\_NA0010\_123\_125\_20180307\_00030.jpg

LM Start	27.01	Rating **	M	Issue No.	125
LM End	27.01	Issue Type +	Ma	Location *	LS
Category	Earthen Levee			GPS Latitude/Longitude	
				Start	End
Item	Encroachments			37.032675 °	37.032675 °
				-120.472841 °	-120.472841 °
DWR ID	DWR_NA0010_05_f_2017_125				
Comment Code					
TR : Tree or limb					
Inspector Comment

Looking north at the landside slope.

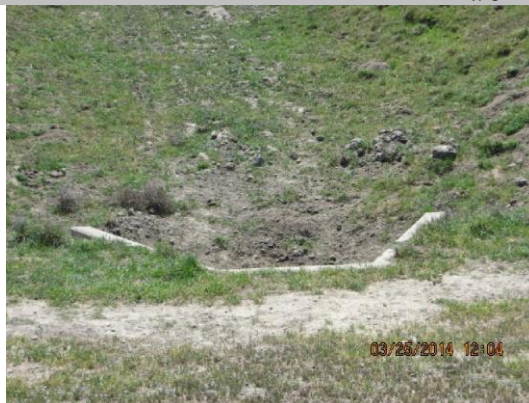
Photo 1 of 3 : UCIP\_SP\_2018\_32807\_59358.jpg

LM Start	27.31	Rating **	A/W	Issue No.	1387
LM End	27.31	Issue Type +	Ma	Location *	
Category	Supplemental			GPS Latitude/Longitude	
				Start	End
Item	DWR UCIP LMA Responsibility			37.032668 °	37.032668 °
				-120.467299 °	-120.467299 °
DWR ID					
Comment Code					
Inspector Comment					
FS_ID:32807 DS_ID:19749 EP_NO: N/A Repair Type: No Action Needed Crossing Status: Found UCIP Comments: FIELD_STRUCT_DESC: 36-inch corrugated metal gravity drainage pipe through the levee, 12 feet below the crown. Flap gate on the waterside (WS) end. Concrete headwall on the landside (LS) end. Concrete U-shaped headwall on the WS end. [Additional Reference(s): DWR Levee Log, 2002. USACE San Joaquin O&M Manual 601.1, 1967, (HLM 27.22)]. FS Date: 3/25/2014

Concrete headwall on WS toe.

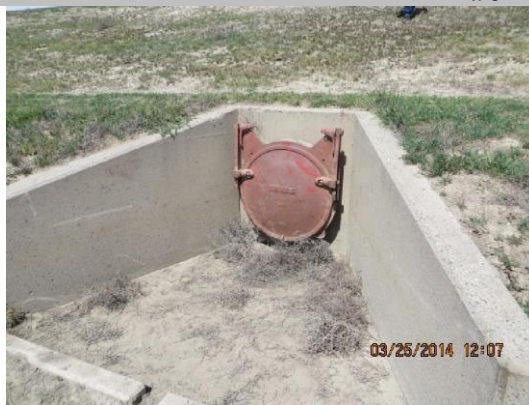
Photo 2 of 3 : UCIP\_SP\_2018\_32807\_59359.jpg

Flapgate at Concrete headwall on WS toe.

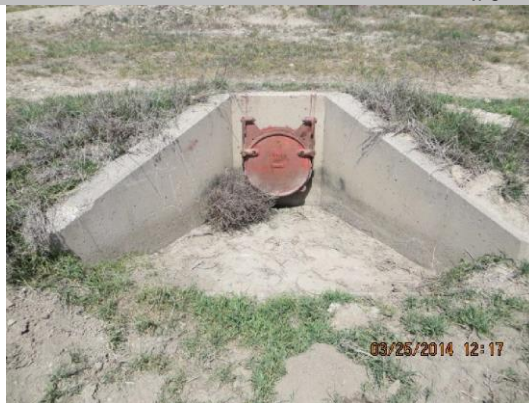
Photo 2 of 3 : UCIP\_SP\_2018\_32823\_59383.jpg

LM Start	28.27	Rating **	M	Issue No.	1388 (cont)	
LM End	28.27	Issue Type +	Ma	Location *		
Category	Supplemental			GPS Latitude/Longitude		
				Start		End
Item	DWR UCIP LMA Responsibility			37.032623 °	37.032623 °	
				-120.450108 °	-120.450108 °	
DWR ID						
Comment Code						
Inspector Comment						
FS_ID:32823 DS_ID:19750 EP_NO: N/A Repair Type: Non-Urgent Crossing Status: Found UCIP Comments: Animal Burrowing activity at LS toe may undermine headwall. FIELD_STRUCT_DESC: 24-inch corrugated metal gravity drainage pipe through the levee, 10.8 feet below the crown. Flap gate on the waterside (WS) end. Concrete headwall on the landside (LS) end. Concrete U-shaped headwall on the WS end. [Additional Reference(s): DWR Levee Log, 2002. USACE San Joaquin O&M Manual 601.1, 1967, (HLM 28.17)]. FS Date: 3/25/2014

Flapgate on Concrete headwall at WS toe.

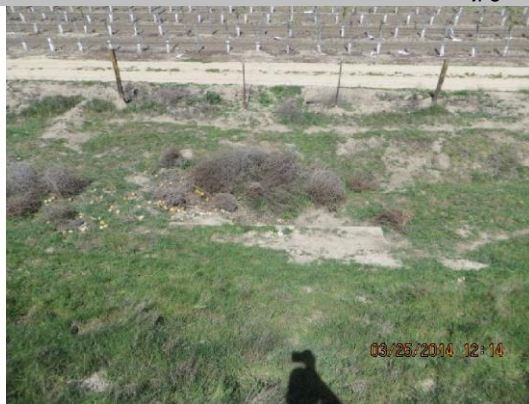
Photo 3 of 3 : UCIP\_SP\_2018\_32823\_59381.jpg

Concrete headwall on LS toe.

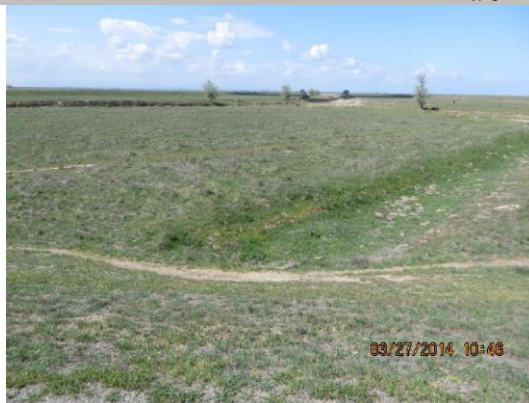
Photo 1 of 3 : UCIP\_SP\_2018\_32832\_59420.jpg

LM Start	28.79	Rating **	A/W	Issue No.	1389
LM End	28.79	Issue Type +	Ma	Location *	
Category	Supplemental			GPS Latitude/Longitude	
				Start	End
Item	DWR UCIP LMA Responsibility			37.031640 °	37.031640 °
				-120.441389 °	-120.441389 °
DWR ID					
Comment Code					
Inspector Comment					
FS_ID:32832 DS_ID:19751 EP_NO: N/A Repair Type: No Action Needed Crossing Status: Found UCIP Comments: FIELD_STRUCT_DESC: 30-inch corrugated metal gravity drainage pipe through the levee, 9.8 feet below the crown. Flap gate on the waterside (WS) end. Concrete headwall on the landside (LS) end. Concrete U-shaped headwall on the WS end. [Additional Reference(s): DWR Levee Log, 2002. USACE San Joaquin O&M Manual 601.1, 1967, (HLM 28.69)]. FS Date: 3/27/2014

Concrete headwall on WS toe.

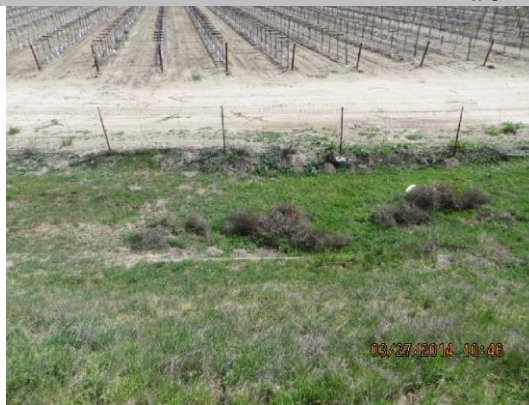
Photo 2 of 3 : UCIP\_SP\_2018\_32832\_59419.jpg

Concrete headwall on LS toe.

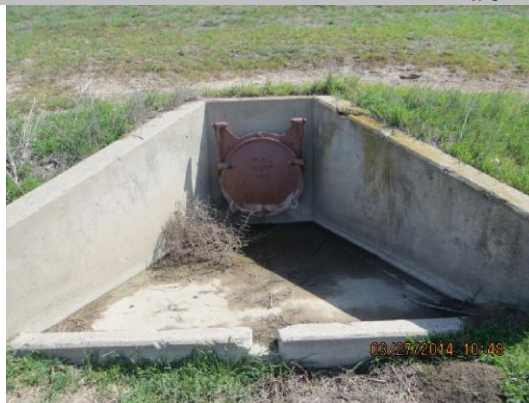
Photo 3 of 3 : UCIP\_SP\_2018\_32832\_59418.jpg

Flapgate on Concrete headwall at WS toe.

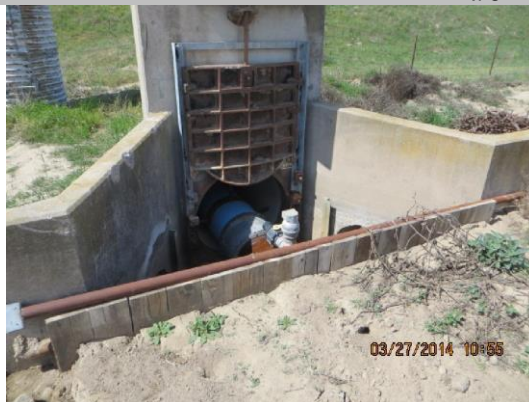
Photo 2 of 3 : UCIP\_SP\_2018\_50055\_59409.jpg

24-inch PVC pipe sleeved through 48-inch concrete pipe.

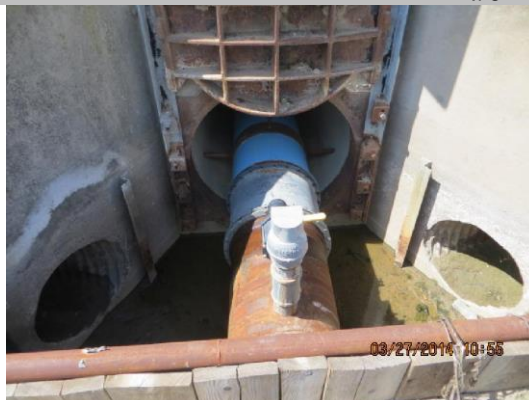
Photo 3 of 3 : UCIP\_SP\_2018\_50055\_59408.jpg

Item	DWR UCIP Field Study			37.028295 °		37.028295 °
				-120.439275 °		-120.439275 °
DWR ID						
Comment Code						
Inspector Comment						
FS_ID:50055 DS_ID:19752 EP_NO: N/A Repair Type: Non-Urgent Crossing Status: Found UCIP Comments: 7/20/2016 same as previous inspection. Crossing has been downgraded from Urgent to Non-Urgent slide gate is on LS. Pipe is buried through WS. Need to coordinate with owner to determine permit used to authorized sleeved pipe. (DWR UCIP - omagana)3/27/2014 Slide gate will not close due to 24-inch PVC pipe sleeved through pipe. Also slide gate rails rusted beyond use. (DWR UCIP - omagana) FIELD_STRUCT_DESC: [Rodunder Siphon Structure] 48-inch reinforced concrete irrigation siphon pipe through the levee, 12.1 feet below the crown. Concrete U-shaped headwall on inlet structure on the landside (LS) end. Slide gate mounted on concrete headwall on the LS. 36-inch corrugated metal pipe (CMP) riser with a slide gate on the LS, 8 feet upstream from the siphon. 24-inch pipe from this unit enters the siphon behind the inlet structure. [Additional Reference(s): DWR Levee Log, 2002. USACE San Joaquin O&M Manual 601.1, 1967, (HLM 28.95)]. FS Date: 7/20/2016

24-inch PVC pipe sleeved through 48-inch concrete pipe. Rails on Slide gate rusted beyond use.

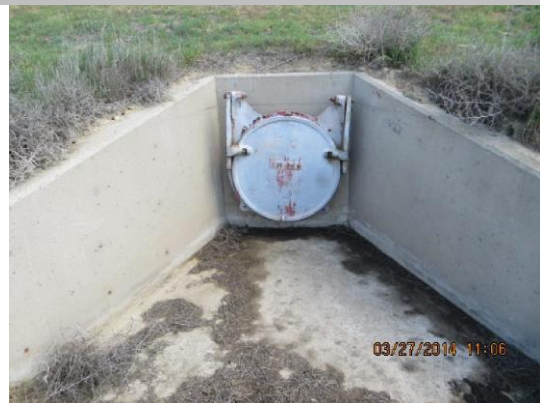
Photo 2 of 3 : UCIP\_SP\_2018\_39884\_59413.jpg

Flapgate on Concrete headwall at WS toe.

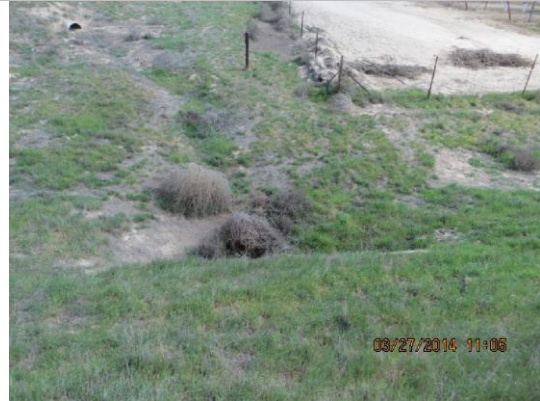
Photo 3 of 3 : UCIP\_SP\_2018\_39884\_59415.jpg

Item	DWR UCIP LMA Responsibility			37.021497 °	37.021497 °	
				-120.434602 °	-120.434602 °	
DWR ID						
Comment Code						
Inspector Comment						
FS_ID:39884 DS_ID:19753 EP_NO: N/A Repair Type: Non-Urgent Crossing Status: Found UCIP Comments: Dense vegetation limits the inspector's visibility to identify signs of pipe failure (leaks) along the landward slope. Recommend removing vegetation along pipe alignment to conduct proper inspection of structure. Sediment buildup in pipe visible from landward side--recommend contacting owner to clear pipe. FIELD_STRUCT_DESC: 36-inch corrugated metal gravity drainage pipe through the levee, 10.2 feet below the crown. Flap gate on the waterside (WS) end. Concrete headwall on the landside (LS) end. Concrete U-shaped headwall on the WS end. [Additional Reference(s): DWR Levee Log, 2002. USACE San Joaquin O&M Manual 601.1, 1967, (HLM 29.49)]. FS Date: 3/27/2014

Concrete headwall on LS toe.

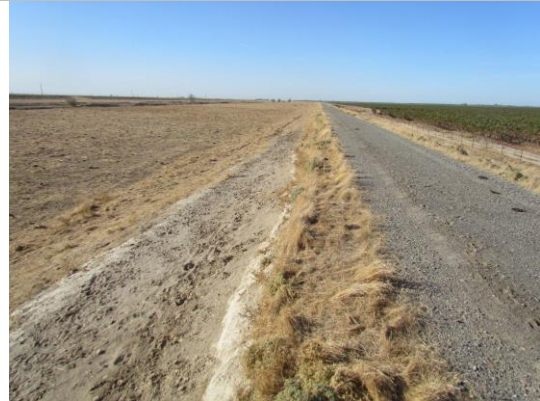
Photo 2 of 2 : SP\_2018\_NA0010\_123\_171\_20180307\_00036.jpg

LM Start	29.68	Rating **	M	Issue No.	171 (cont)
LM End	29.80	Issue Type +	Ma	Location *	WS
Category	Earthen Levee			GPS Latitude/Longitude	
				Start	End
Item	Erosion / Bank Caving			37.020272 °	37.018712 °
				-120.433737 °	-120.432682 °
DWR ID	DWR_NA0010_05_s_2014_171				
Comment Code					
E1 : Note and monitor erosion site.					
Inspector Comment					
Waterside erosion caused by livestock.

Looking north at animal erosion on waterward slope.

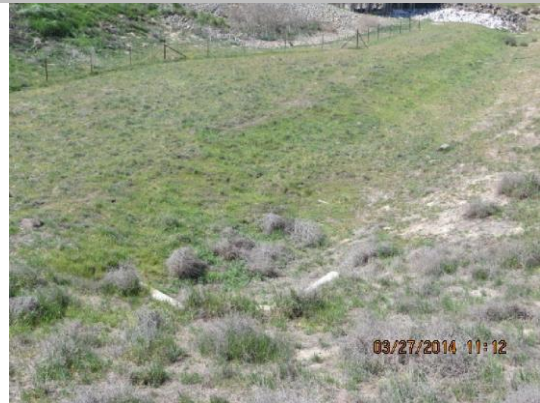
Photo 1 of 3 : UCIP\_SP\_2018\_39631\_59424.jpg

Comment Code					
Inspector Comment					
FS_ID:39631 DS_ID:19754 EP_NO: N/A Repair Type: Non-Urgent Crossing Status: Found UCIP Comments: Dense vegetation limits the inspector's visibility to identify signs of pipe failure (leaks) along the landward slope. Recommend removing vegetation along pipe alignment to conduct proper inspection of structure. FIELD_STRUCT_DESC: 30-inch by 30-inch reinforced concrete box gravity drainage culvert through the levee, 12 feet below the crown. Flap gate on the waterside (WS) end. Concrete headwall on the landside (LS) end. Concrete U-shaped headwall on the WS end. [Additional Reference(s): DWR Levee Log, 2002. USACE San Joaquin O&M Manual 601.1, 1967, (HLM 29.72)]. FS Date: 3/27/2014

Concrete headwall on WS toe.

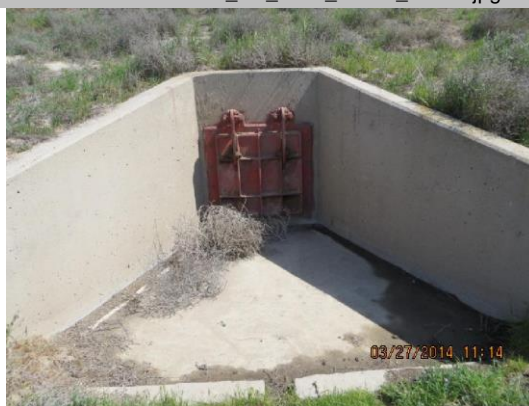
Photo 2 of 3 : UCIP\_SP\_2018\_39631\_59426.jpg

Flapgate on Concrete headwall at WS toe.

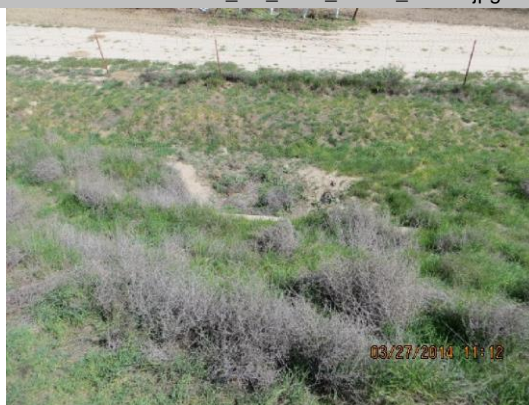
Photo 3 of 3 : UCIP\_SP\_2018\_39631\_59425.jpg

Concrete headwall on LS toe.

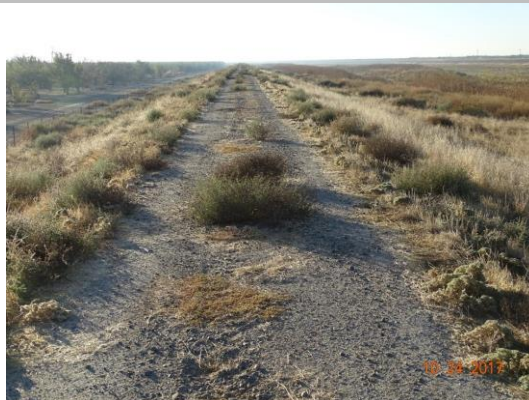
Photo 1 of 1 : SP\_2018\_NA0010\_123\_128\_20180307\_00033.jpg

LM Start	29.88	Rating **	A/W	Issue No.	128
LM End	31.19	Issue Type +	Ma	Location *	CR
Category	Earthen Levee			GPS Latitude/Longitude	
				Start	End
Item	Vegetation			37.017747 °	37.002885 °
				-120.432013 °	-120.417550 °
DWR ID	DWR_NA0010_05_f_2017_128				
Comment Code					
V9 : Keep the crown roadway free of vegetation.					
Inspector Comment

Looking southeast at the crown.

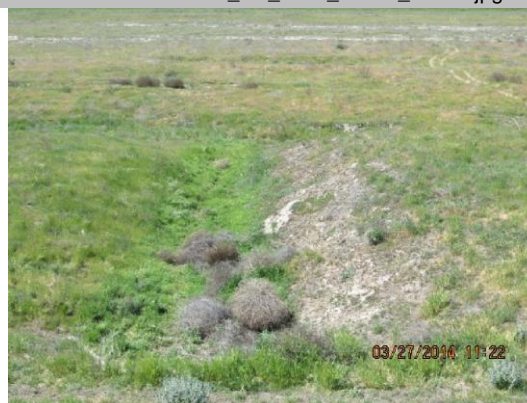
Photo 1 of 3 : UCIP\_SP\_2018\_39632\_59430.jpg

Comment Code					
Inspector Comment					
FS_ID:39632					
DS_ID:19696					
EP_NO: N/A					
Repair Type: Non-Urgent					
Crossing Status: Found					
UCIP Comments: Dense vegetation limits the inspector's visibility to identify signs of pipe failure (leaks) along the landward slope.					
Recommend removing vegetation along pipe alignment to conduct proper inspection of structure.					
FIELD_STRUCT_DESC: 30-inch by 30-inch reinforced concrete box gravity drainage culvert through the levee, 13.1 feet below the crown. Flap gate on the waterside (WS) end. Concrete headwall on the landside (LS) end. Concrete U-shaped headwall on the WS end.					
[Additional Reference(s): DWR Levee Log, 2002. USACE San Joaquin O&M Manual 601.1, 1967, (HLM 30.04)].					
FS Date: 3/27/2014

Concrete headwall on WS toe.

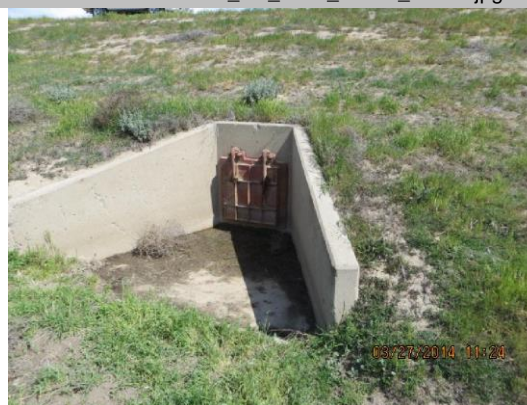
Photo 2 of 3 : UCIP\_SP\_2018\_39632\_59431.jpg

Flapgate on Concrete headwall at WS toe.

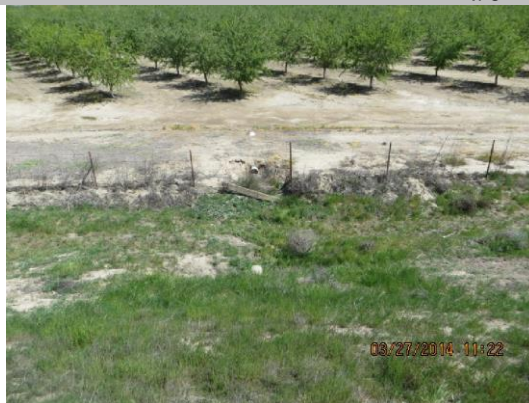
Photo 3 of 3 : UCIP\_SP\_2018\_39632\_59429.jpg

Item	DWR UCIP LMA Responsibility			37.014471 °	37.014471 °	
				-120.429759 °	-120.429759 °	
DWR ID						
Comment Code						
Inspector Comment						
FS_ID:39632						
DS_ID:19696						
EP_NO: N/A						
Repair Type: Non-Urgent						
Crossing Status: Found						
UCIP Comments: Dense vegetation limits the inspector's visibility to identify signs of pipe failure (leaks) along the landward slope.						
Recommend removing vegetation along pipe alignment to conduct proper inspection of structure.						
FIELD_STRUCT_DESC: 30-inch by 30-inch reinforced concrete box gravity drainage culvert through the levee, 13.1 feet below the crown.						
Flap gate on the waterside (WS) end. Concrete headwall on the landside (LS) end. Concrete U-shaped headwall on the WS end.						
[Additional Reference(s): DWR Levee Log, 2002. USACE San Joaquin O&M Manual 601.1, 1967, (HLM 30.04)].						
FS Date: 3/27/2014

Concrete headwall on LS toe.

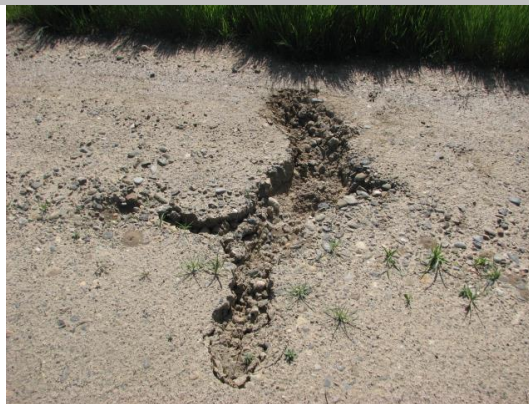
Photo 1 of 2 : SP\_2018\_NA0010\_123\_133\_20180411\_00312.jpg

LM Start	30.33	Rating **	M	Issue No.	133
LM End	30.33	Issue Type +	Ma	Location *	CR
Category	Earthen Levee			GPS Latitude/Longitude	
				Start	End
Item	Crown Surface / Depressions / Rutting			37.012070 °	37.012070 °
				-120.428101 °	-120.428101 °
DWR ID	DWR_NA0010_05_s_2018_133				
Comment Code					
C2 : Repair depressions or ruts in the crown or slope.					
Inspector Comment					
Minor depression on levee crown. Possible sink hole.

Looking east at depression on levee crown. (Spring 2018)

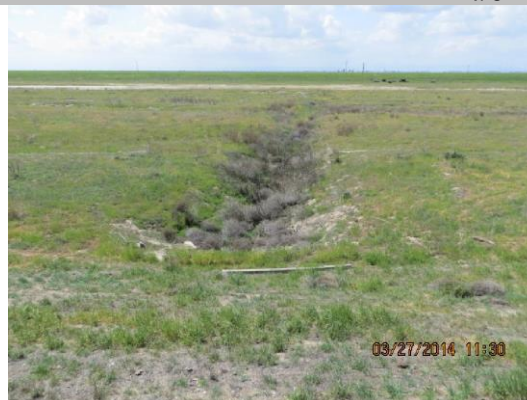
Photo 1 of 3 : UCIP\_SP\_2018\_39633\_59435.jpg

Comment Code						
Inspector Comment						
FS_ID:39633						
DS_ID:19697						
EP_NO: N/A						
Repair Type: Non-Urgent						
Crossing Status: Found						
UCIP Comments: Some debris buildup at LS toe. Dense vegetation limits the inspector's visibility to identify signs of pipe failure (leaks) along the landward slope. Recommend removing vegetation along pipe alignment to conduct proper inspection of structure.						
FIELD_STRUCT_DESC: 30-inch by 30-inch reinforced concrete box gravity drainage culvert through the levee, 13.3 feet below the crown. Flap gate on the waterside (WS) end. Concrete headwall on the landside (LS) end. Concrete U-shaped headwall on the WS end.						
[Additional Reference(s): DWR Levee Log, 2002. USACE San Joaquin O&M Manual 601.1, 1967, (HLM 30.96)].						
FS Date: 3/27/2014

Concrete headwall on WS toe.

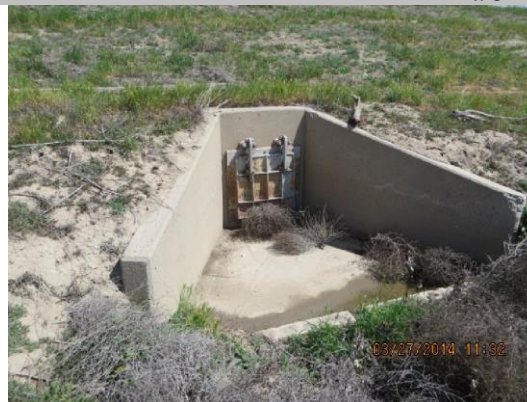
Photo 2 of 3 : UCIP\_SP\_2018\_39633\_59436.jpg

Flapgate on Concrete headwall at WS toe.

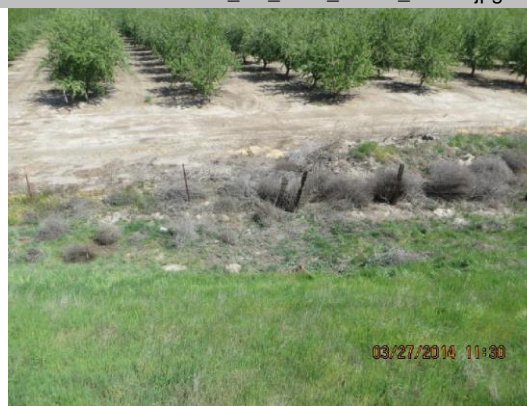
Photo 3 of 3 : UCIP\_SP\_2018\_39633\_59434.jpg

Item	DWR UCIP LMA Responsibility			37.004212	°	37.004212
				-120.419178	°	-120.419178
DWR ID						
Comment Code						
Inspector Comment						
FS_ID:39633						
DS_ID:19697						
EP_NO: N/A						
Repair Type: Non-Urgent						
Crossing Status: Found						
UCIP Comments: Some debris buildup at LS toe. Dense vegetation limits the inspector's visibility to identify signs of pipe failure (leaks) along the landward slope. Recommend removing vegetation along pipe alignment to conduct proper inspection of structure.						
FIELD_STRUCT_DESC: 30-inch by 30-inch reinforced concrete box gravity drainage culvert through the levee, 13.3 feet below the crown. Flap gate on the waterside (WS) end. Concrete headwall on the landside (LS) end. Concrete U-shaped headwall on the WS end. [Additional Reference(s): DWR Levee Log, 2002. USACE San Joaquin O&M Manual 601.1, 1967, (HLM 30.96)].						
FS Date: 3/27/2014

Concrete headwall on LS toe.

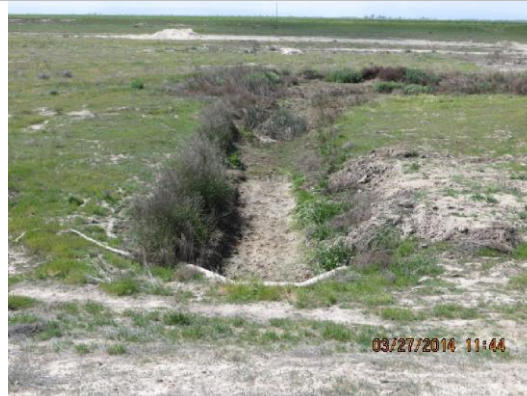
Photo 1 of 3 : UCIP\_SP\_2018\_39643\_59439.jpg

Comment Code					
Inspector Comment					
FS_ID:39643 DS_ID:19698 EP_NO: N/A Repair Type: Non-Urgent Crossing Status: Found UCIP Comments: Excess vegetation buildup at inlet on LS toe. Dense vegetation limits the inspector's visibility to identify signs of pipe failure (leaks) along the landward slope. Recommend removing vegetation along pipe alignment to conduct proper inspection of structure. FIELD_STRUCT_DESC: 30-inch by 30-inch reinforced concrete box gravity drainage culvert through the levee, 13.4 feet below the crown. Flap gate on the waterside (WS) end. Concrete headwall on the landside (LS) end. Concrete U-shaped headwall on the WS end. [Additional Reference(s): DWR Levee Log, 2002. USACE San Joaquin O&M Manual 601.1, 1967, (HLM 31.19)]. FS Date: 3/27/2014

Concrete headwall on WS toe.

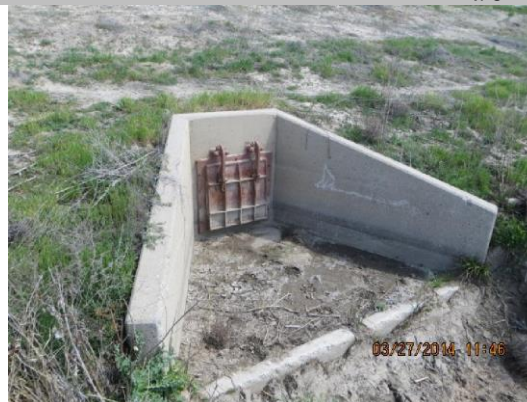
Photo 2 of 3 : UCIP\_SP\_2018\_39643\_59440.jpg

Flapgate at concrete headwall on WS toe.

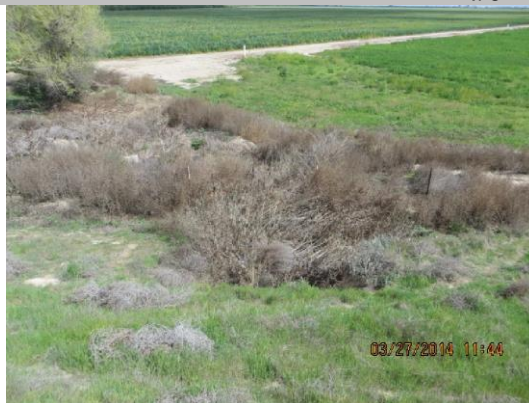
Photo 3 of 3 : UCIP\_SP\_2018\_39643\_59438.jpg

Item	DWR UCIP LMA Responsibility			37.001754 °	37.001754 °	
				-120.416254 °	-120.416254 °	
DWR ID						
Comment Code						
Inspector Comment						
FS_ID:39643						
DS_ID:19698						
EP_NO: N/A						
Repair Type: Non-Urgent						
Crossing Status: Found						
UCIP Comments: Excess vegetation buildup at inlet on LS toe. Dense vegetation limits the inspector's visibility to identify signs of pipe failure (leaks) along the landward slope. Recommend removing vegetation along pipe alignment to conduct proper inspection of structure.						
FIELD_STRUCT_DESC: 30-inch by 30-inch reinforced concrete box gravity drainage culvert through the levee, 13.4 feet below the crown.						
Flap gate on the waterside (WS) end. Concrete headwall on the landside (LS) end. Concrete U-shaped headwall on the WS end.						
[Additional Reference(s): DWR Levee Log, 2002. USACE San Joaquin O&M Manual 601.1, 1967, (HLM 31.19)].

Concrete headwall on LS toe.

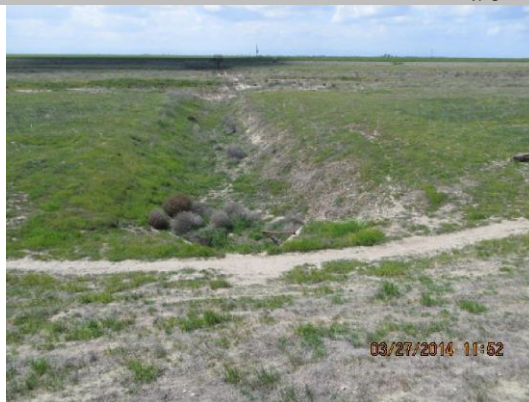
Photo 1 of 3 : UCIP\_SP\_2018\_39644\_59444.jpg

LM Start	31.74	Rating **	A/W	Issue No.	1396
LM End	31.74	Issue Type +	Ma	Location *	
Category	Supplemental			GPS Latitude/Longitude	
				Start	End
Item	DWR UCIP LMA Responsibility			36.997001 °	36.997001 °
				-120.410991 °	-120.410991 °
DWR ID					
Comment Code					
Inspector Comment					
FS_ID:39644					
DS_ID:19699					
EP_NO: N/A					
Repair Type: No Action Needed					
Crossing Status: Found					
UCIP Comments:					
FIELD_STRUCT_DESC: 48-inch by 36-inch reinforced concrete box gravity drainage culvert through the levee, 14.5 feet below the crown. Flap gate on the waterside (WS) end. Concrete U-shaped headwall on each end. [Additional Reference(s): DWR Levee Log, 2002. USACE San Joaquin O&M Manual 601.1, 1967, (HLM 31.64)].					
FS Date: 3/27/2014

Concrete headwall on WS toe.

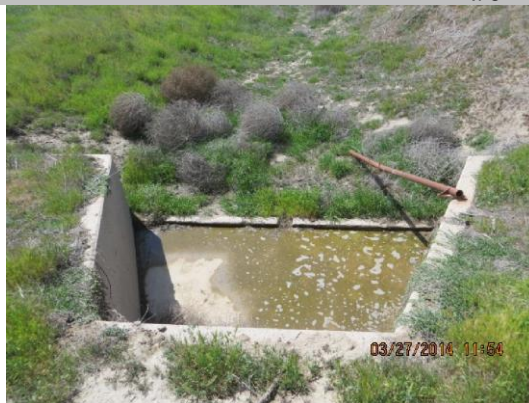
Photo 2 of 3 : UCIP\_SP\_2018\_39644\_59442.jpg

Concrete headwall on WS toe.

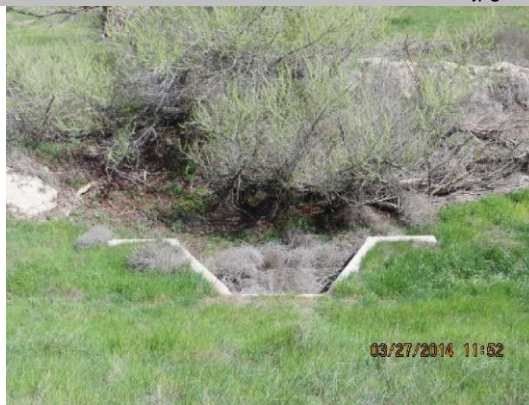
Photo 3 of 3 : UCIP\_SP\_2018\_39644\_59443.jpg

Concrete headwall on LS toe. Note tumbleweeds blocking inlet.
