**Flood Control Project Maintenance  
Levee Inspections**  
**LMA District Cover Sheet**  
**Spring 2018 Levee Inspection Results**

**Lower San Joaquin Levee District**

**Spring 2018 Levee Inspection Results**

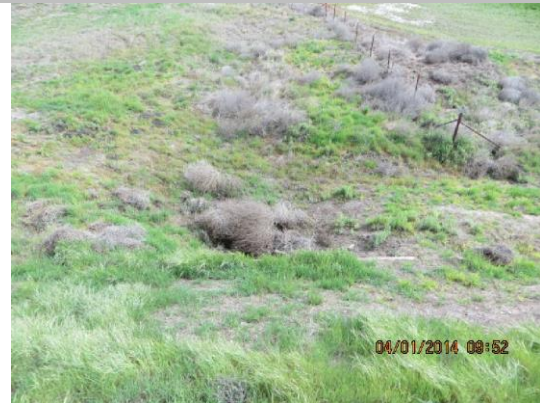
Photo 3 of 3 : UCIP\_SP\_2018\_39645\_59685.jpg

Item	DWR UCIP LMA Responsibility			36.995029 °	36.995029 °	
				-120.408914 °	-120.408914 °	
DWR ID						
Comment Code						
Inspector Comment						
FS_ID:39645 DS_ID:19700 EP_NO: N/A Repair Type: Non-Urgent Crossing Status: Found UCIP Comments: Dense vegetation limits the inspector's visibility to identify signs of pipe failure (leaks) along the landward slope. Recommend removing vegetation along pipe alignment to conduct proper inspection of structure. FIELD_STRUCT_DESC: 30-inch by 30-inch reinforced concrete box gravity drainage culvert through the levee, 13 feet below the crown. Flap gate on the waterside (WS) end. Concrete headwall on the landside (LS) end with flashboard attachment. Concrete U-shaped headwall on the WS end. [Additional Reference(s): DWR Levee Log, 2002. USACE San Joaquin O&M Manual 601.1, 1967, (HLM 31.71)]. FS Date: 4/1/2014

Concrete headwall on LS toe.

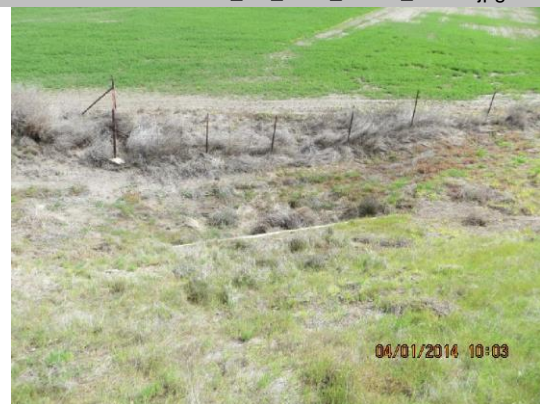
Photo 1 of 3 : UCIP\_SP\_2018\_39646\_59690.jpg

LM Start	32.32	Rating **	M	Issue No.	1398
LM End	32.32	Issue Type +	Ma	Location *	
Category	Supplemental			GPS Latitude/Longitude	
				Start	End
Item	DWR UCIP LMA Responsibility			36.989435 °	36.989435 °
				-120.402626 °	-120.402626 °
DWR ID					
Comment Code					
Inspector Comment					
FS_ID:39646 DS_ID:19701 EP_NO: N/A Repair Type: Non-Urgent Crossing Status: Found UCIP Comments: Some silt buildup inside culvert. FIELD_STRUCT_DESC: 30-inch by 30-inch reinforced concrete box gravity drainage culvert through the levee, 14.2 feet below the crown. Flap gate on the waterside (WS) end. Concrete headwall on the landside (LS) end with flashboard attachment. Concrete U-shaped headwall on the WS end. [Additional Reference(s): DWR Levee Log, 2002. USACE San Joaquin O&M Manual 601.1, 1967, (HLM 32.22)]. FS Date: 4/1/2014

Concrete headwall at inlet on LS toe.

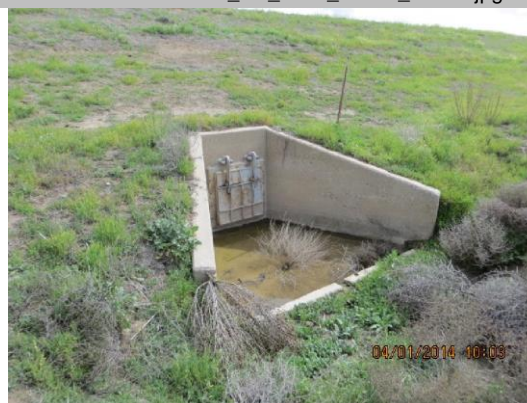
Photo 2 of 3 : UCIP\_SP\_2018\_39646\_59688.jpg

Flapgate on Concrete headwall at WS toe.

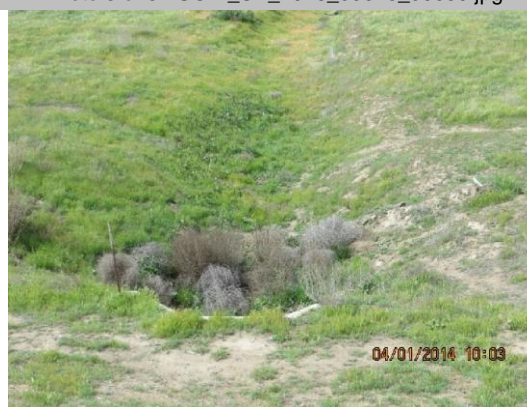
Photo 3 of 3 : UCIP\_SP\_2018\_39646\_59689.jpg

Concrete headwall at outlet on WS toe.

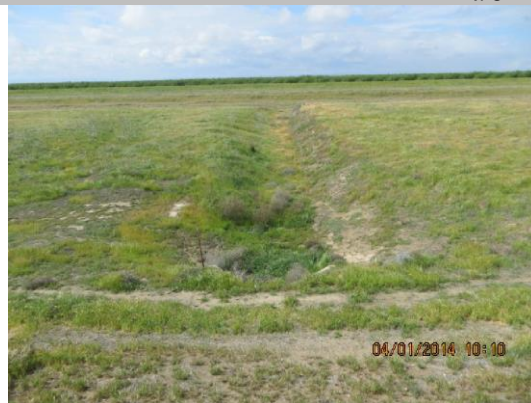
Photo 1 of 3 : UCIP\_SP\_2018\_39647\_59697.jpg

FS\_ID:39647  
DS\_ID:19702  
EP\_NO: N/A  
Repair Type: Non-Urgent  
Crossing Status: Found  
UCIP Comments: Dense vegetation limits the inspector's visibility to identify signs of pipe failure (leaks) along the landward slope. Recommend removing vegetation along pipe alignment to conduct proper inspection of structure. Debris buildup blocking landward headwall--recommend contacting owner to clear debris.  
FIELD\_STRUCT\_DESC: 30-inch by 30-inch reinforced concrete box gravity drainage culvert through the levee, 12.2 feet below the crown. Flap gate on the waterside (WS) end. Concrete headwall on the landside (LS) end. Concrete U-shaped headwall on the WS end.  
[Additional Reference(s): DWR Levee Log, 2002. USACE San Joaquin O&M Manual 601.1, 1967, (HLM 33.01)].  
FS Date: 4/1/2014

Concrete headwall at WS toe.

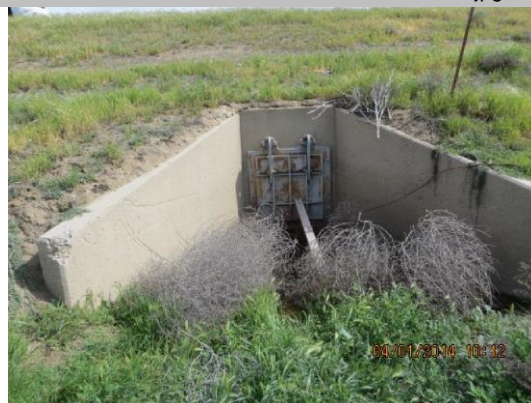
Photo 2 of 3 : UCIP\_SP\_2018\_39647\_59699.jpg

Flapgate on Concrete headwall at WS toe.

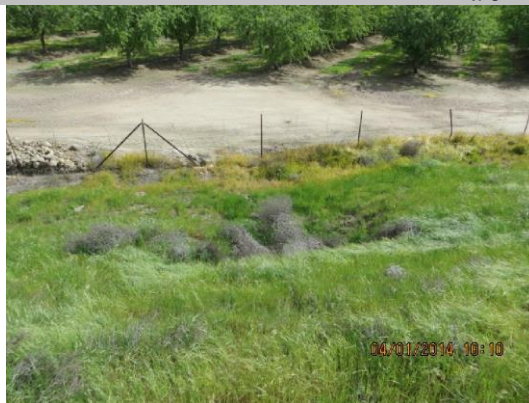
Photo 3 of 3 : UCIP\_SP\_2018\_39647\_59698.jpg

Item	DWR UCIP LMA Responsibility			36.980861 °		36.980861 °
				-120.393116 °		-120.393116 °
DWR ID						
Comment Code						
Inspector Comment						
FS_ID:39647 DS_ID:19702 EP_NO: N/A Repair Type: Non-Urgent Crossing Status: Found UCIP Comments: Dense vegetation limits the inspector's visibility to identify signs of pipe failure (leaks) along the landward slope. Recommend removing vegetation along pipe alignment to conduct proper inspection of structure. Debris buildup blocking landward headwall--recommend contacting owner to clear debris. FIELD_STRUCT_DESC: 30-inch by 30-inch reinforced concrete box gravity drainage culvert through the levee, 12.2 feet below the crown. Flap gate on the waterside (WS) end. Concrete headwall on the landside (LS) end. Concrete U-shaped headwall on the WS end. [Additional Reference(s): DWR Levee Log, 2002. USACE San Joaquin O&M Manual 601.1, 1967, (HLM 33.01)]. FS Date: 4/1/2014

Concrete headwall at inlet on LS toe.

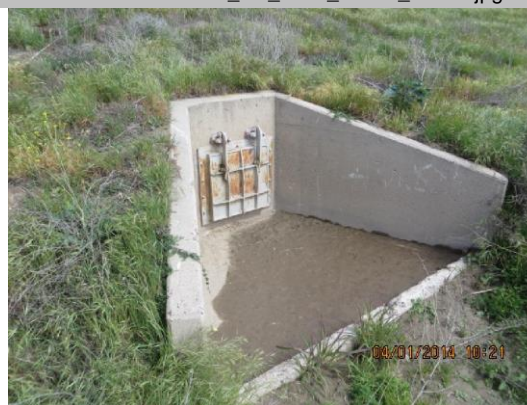
Photo 2 of 3 : UCIP\_SP\_2018\_39648\_59700.jpg

Flapgate on Concrete headwall at WS toe.

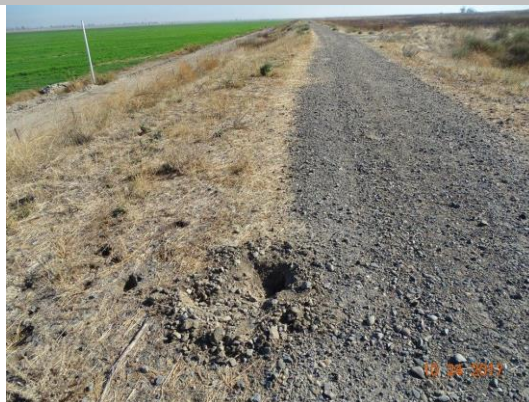
Photo 1 of 1 : SP\_2018\_NA0010\_123\_130\_20180307\_00034.jpg

LM Start	33.82	Rating **	M	Issue No.	130
LM End	33.82	Issue Type +	Ma	Location *	LS
Category	Earthen Levee			GPS Latitude/Longitude	
				Start	End
Item	Animal Control			36.976849 °	36.976849 °
				-120.382393 °	-120.382393 °
DWR ID	DWR_NA0010_05_f_2017_130				
Comment Code					
A3 : No rodents visible, but rodent burrows visible; need to backfill and compact or grout burrows.					
Inspector Comment

Looking east at the landside shoulder.

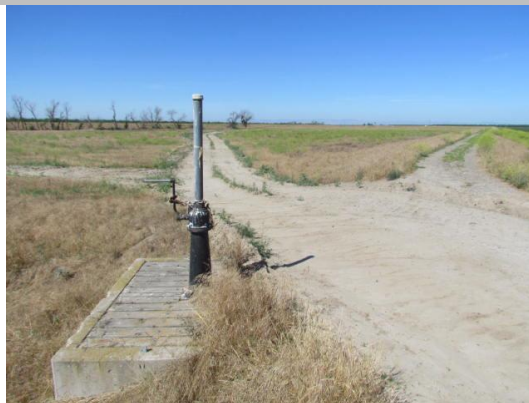
Photo 1 of 4 : SP\_2018\_NA0010\_123\_11\_20180307\_00010.jpg

LM Start	34.61	Rating **	M	Issue No.	11
LM End	34.61	Issue Type +	En	Location *	WS
Category	Earthen Levee			GPS Latitude/Longitude	
				Start	End
Item	Encroachments			36.978523 °	36.978523 °
				-120.368520 °	-120.368520 °
DWR ID	DWR_NA0010_05_s_2012_11				
Comment Code					
RA : Ramp					
Inspector Comment					
Unauthorized ramp on waterside slope. Landowner cut unauthorized ramp on waterside slope and levee crown.

Looking west at ramp on waterward slope.

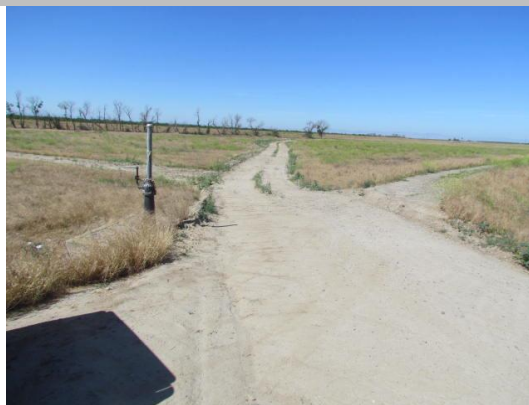
Photo 2 of 4 : SP\_2018\_NA0010\_123\_11\_20180307\_00011.jpg

Looking west at cut on levee crown.

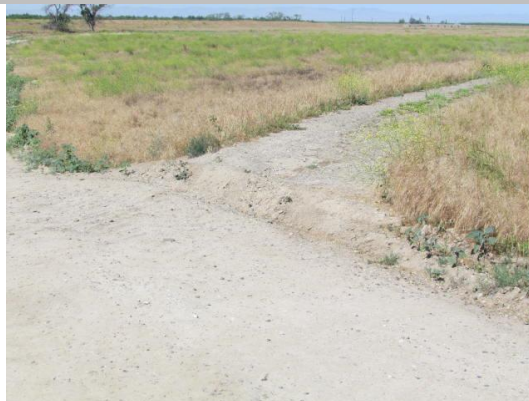
Photo 3 of 4 : SP\_2018\_NA0010\_123\_11\_20180307\_00012.jpg

Looking at cut on levee crown.

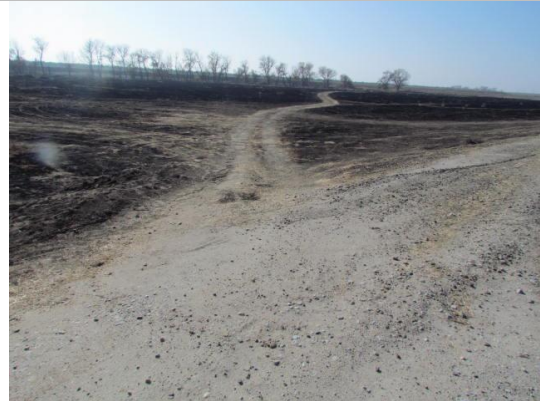
Photo 4 of 4 : SP\_2018\_NA0010\_123\_11\_20180307\_00013.jpg

LM Start	34.61	Rating **	M	Issue No.	11 (cont)	
LM End	34.61	Issue Type +	En	Location *	WS	
Category	Earthen Levee			GPS Latitude/Longitude		
				Start	End	
Item	Encroachments			36.978523 °	36.978523 °	
				-120.368520 °	-120.368520 °	
DWR ID	DWR_NA0010_05_s_2012_11					
Comment Code						
RA : Ramp						
Inspector Comment						
Unauthorized ramp on waterside slope. Landowner cut unauthorized ramp on waterside slope and levee crown.

Looking southwest at unauthorized ramp on waterward slope. (2015)

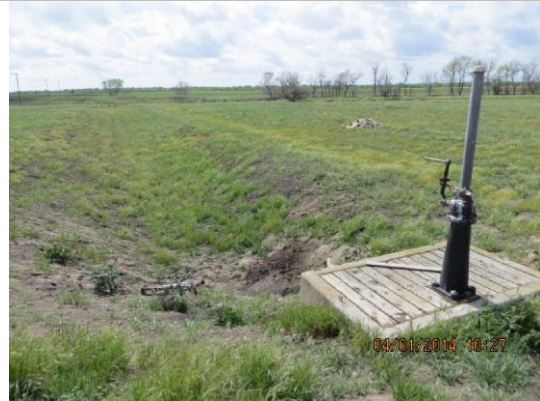
Photo 1 of 3 : UCIP\_SP\_2018\_39649\_59706.jpg

Comment Code					
Inspector Comment					
FS_ID:39649 DS_ID:19755 EP_NO: N/A Repair Type: Non-Urgent Crossing Status: Found UCIP Comments: Dense vegetation limits the inspector's visibility to identify signs of pipe failure (leaks) along the landward slope. Recommend removing vegetation along pipe alignment to conduct proper inspection of structure. Debris buildup visible on waterward headwall--recommend contacting owner to clear pipe. FIELD_STRUCT_DESC: [Chowchilla Canal Irrigation Structure] 36-inch by 36-inch reinforced concrete box gravity irrigation culvert through the levee, 9.7 feet below the crown. Slide gate in a 56-inch by 91-inch concrete riser on the waterside (WS) slope. Concrete U-shaped headwall on each end. Landside channel cobble revetted for 8 feet. [Additional Reference(s): DWR Levee Log, 2002. USACE San Joaquin O&M Manual 601.1, 1967, (HLM 34.51)]. FS Date: 4/1/2014

Slide gate in concrete riser on WS shoulder.

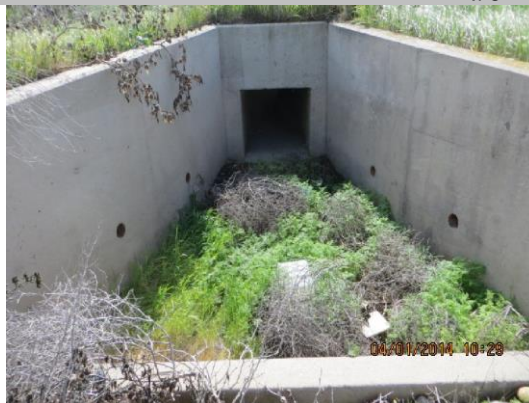
Photo 2 of 3 : UCIP\_SP\_2018\_39649\_59704.jpg

Item	DWR UCIP Field Study			36.978593 °	36.978593 °	
				-120.368511 °	-120.368511 °	
DWR ID						
Comment Code						
Inspector Comment						
FS_ID:39649 DS_ID:19755 EP_NO: N/A Repair Type: Non-Urgent Crossing Status: Found UCIP Comments: Dense vegetation limits the inspector's visibility to identify signs of pipe failure (leaks) along the landward slope. Recommend removing vegetation along pipe alignment to conduct proper inspection of structure. Debris buildup visible on waterward headwall--recommend contacting owner to clear pipe. FIELD_STRUCT_DESC: [Chowchilla Canal Irrigation Structure] 36-inch by 36-inch reinforced concrete box gravity irrigation culvert through the levee, 9.7 feet below the crown. Slide gate in a 56-inch by 91-inch concrete riser on the waterside (WS) slope. Concrete U-shaped headwall on each end. Landside channel cobble revetted for 8 feet. [Additional Reference(s): DWR Levee Log, 2002. USACE San Joaquin O&M Manual 601.1, 1967, (HLM 34.51)]. FS Date: 4/1/2014

Concrete headwall at LS toe.

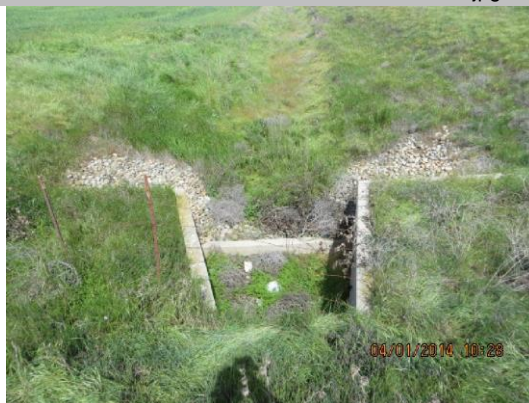
Photo 3 of 3 : UCIP\_SP\_2018\_39649\_59705.jpg

Concrete headwall at LS toe.

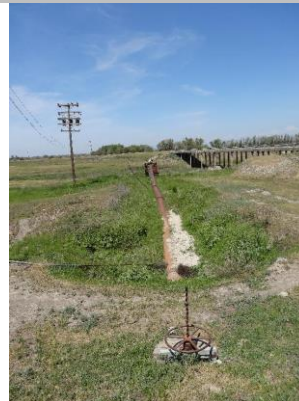
Photo 1 of 3 : UCIP\_SP\_2018\_39463\_66341.jpg

LM Start	0.66	Rating **	M	Issue No.	1213	
LM End	0.66	Issue Type +	En	Location *		
Category	Supplemental			GPS Latitude/Longitude		
				Start		End
Item	DWR UCIP Field Study			37.271444 °		37.271444 °
				-120.815835 °		-120.815835 °
DWR ID						
Comment Code						
Inspector Comment						
FS_ID:39463 DS_ID:19815 EP_NO: N/A Repair Type: Non-Urgent Crossing Status: Found UCIP Comments: Need to contact owner. Sediment buildup on landward side. Recommend removing sediment buildup on landward toe. FIELD_STRUCT_DESC: 24-inch corrugated metal irrigation discharge pipe through the levee, 7.2 feet below the crown. Pump on concrete structure in the channel. Slide gate in a 36-inch corrugated metal pipe (CMP) riser on the waterside (WS) slope. Concrete headwall on each end. [Additional Reference(s): DWR Levee Log, 2002. USACE San Joaquin O&M Manual 601.1, 1967, (HLM 0.74)]. FS Date: 4/18/2014

View of waterward side.

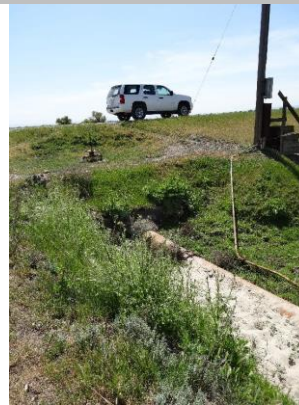
Photo 2 of 3 : UCIP\_SP\_2018\_39463\_66343.jpg

View of slope on waterward side.

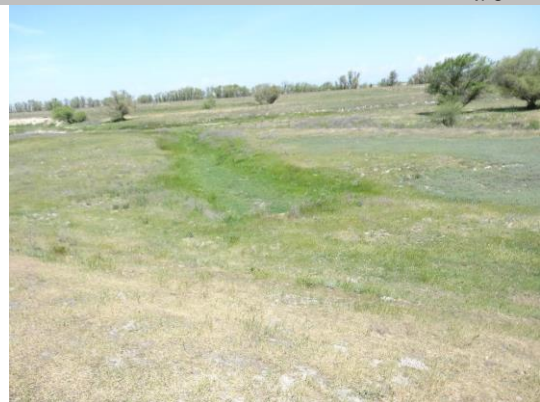
Photo 1 of 3 : UCIP\_SP\_2018\_36565\_66346.jpg

LM Start	0.78	Rating **	M	Issue No.	1214
LM End	0.78	Issue Type +	Ma	Location *	
Category	Supplemental			GPS Latitude/Longitude	
				Start	End
Item	DWR UCIP LMA Responsibility			37.270460 °	37.270460 °
				-120.814290 °	-120.814290 °
DWR ID					
Comment Code					
Inspector Comment					
FS_ID:36565 DS_ID:19816 EP_NO: N/A Repair Type: Non-Urgent Crossing Status: Found UCIP Comments: Landward side blocked--need to contact owner to determine status of crossing. FIELD_STRUCT_DESC: 24-inch corrugated metal gravity drainage pipe through the levee, 16.2 feet below the crown. Flap gate on the waterside (WS) end. Concrete U-shaped headwall on each end. [Additional Reference(s): DWR Levee Log, 2002. USACE San Joaquin O&M Manual 601.1, 1967, (HLM 0.86)]. FS Date: 4/18/2014

Overview of waterward side.

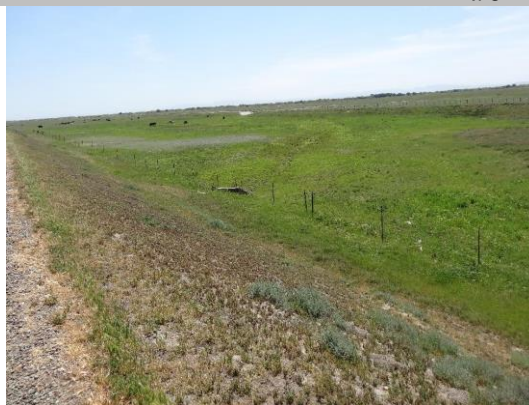
Photo 3 of 3 : UCIP\_SP\_2018\_36565\_66344.jpg

View of landward side.

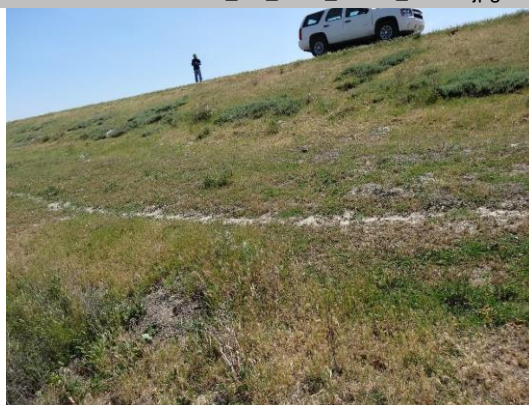
Photo 1 of 3 : UCIP\_SP\_2018\_36566\_66348.jpg

LM Start	1.87	Rating **	M	Issue No.	1215
LM End	1.87	Issue Type +	Ma	Location *	
Category	Supplemental			GPS Latitude/Longitude	
				Start	End
Item	DWR UCIP LMA Responsibility			37.259312 °	37.259312 °
				-120.802863 °	-120.802863 °
DWR ID					
Comment Code					
Inspector Comment					
FS_ID:36566 DS_ID:19817 EP_NO: N/A Repair Type: Non-Urgent Crossing Status: Found UCIP Comments: No access was available to landward side due to fence. Recommend removing some of the vegetation on waterward toe. FIELD_STRUCT_DESC: 24-inch corrugated metal gravity drainage pipe through the levee, 13.5 feet below the crown. Flap gate on the waterside (WS) end. Concrete headwall on each end. [Additional Reference(s): DWR Levee Log, 2002. USACE San Joaquin O&M Manual 601.1, 1967, (HLM 1.95)]. FS Date: 4/18/2014

View of waterward side.

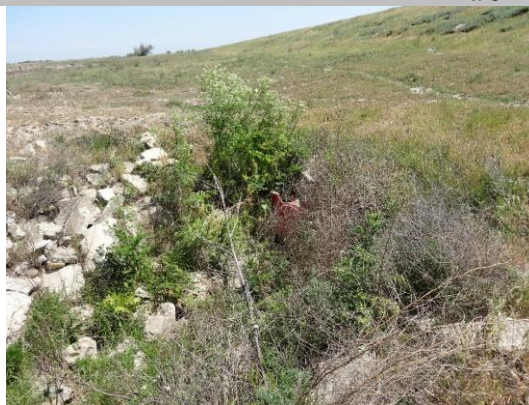
Photo 3 of 3 : UCIP\_SP\_2018\_36566\_66349.jpg

Flap gate visible on waterward side.

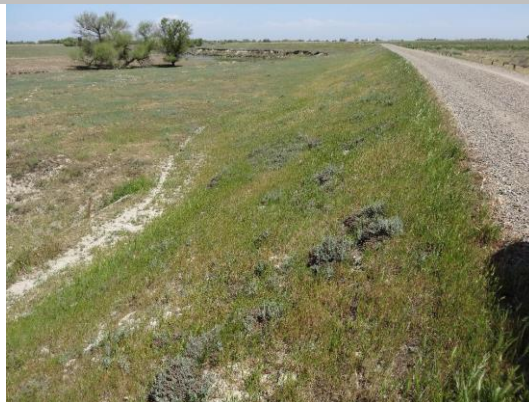
Photo 2 of 3 : UCIP\_SP\_2018\_36568\_66360.jpg

View of waterward side.

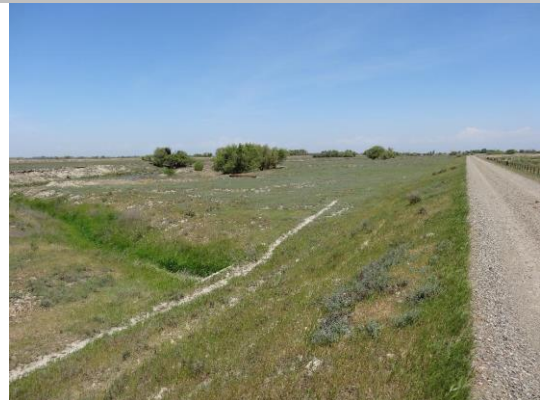
Photo 1 of 3 : UCIP\_SP\_2018\_36569\_66369.jpg

LM Start	2.77	Rating **	M	Issue No.	1218	
LM End	2.77	Issue Type +	Ma	Location *		
Category	Supplemental			GPS Latitude/Longitude		
				Start		End
Item	DWR UCIP LMA Responsibility			37.253020 °		37.253020 °
				-120.790219 °		-120.790219 °
DWR ID						
Comment Code						
Inspector Comment						
FS_ID:36569 DS_ID:19820 EP_NO: N/A Repair Type: Non-Urgent Crossing Status: Found UCIP Comments: Dense vegetation limits the inspector's visibility to identify signs of pipe condition on landward toe--headwall blocked by dense vegetation. Recommend removing vegetation from landward toe. FIELD_STRUCT_DESC: 24-inch corrugated metal gravity drainage pipe through the levee, 10.5 feet below the crown. Flap gate on the waterside (WS) end. Concrete headwall on each end. [Additional Reference(s): DWR Levee Log, 2002. USACE San Joaquin O&M Manual 601.1, 1967, (HLM 2.85)]. FS Date: 4/18/2014

View of waterward side.

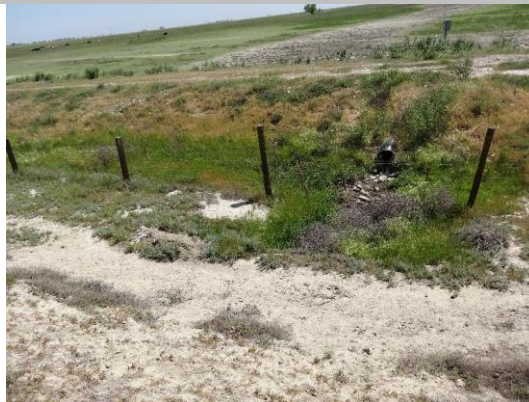
Photo 3 of 3 : UCIP\_SP\_2018\_36569\_66372.jpg

View of landward side.

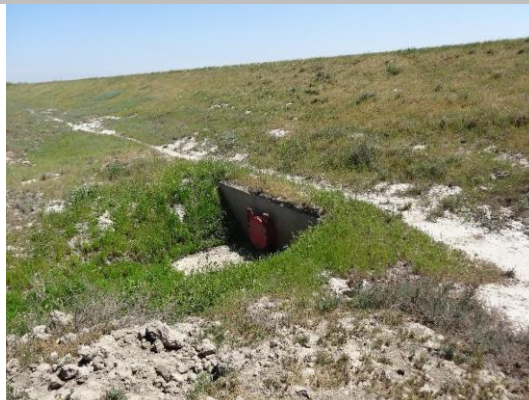
Photo 2 of 3 : UCIP\_SP\_2018\_36583\_66380.jpg

Flap gate and concrete headwall visible on waterward side.

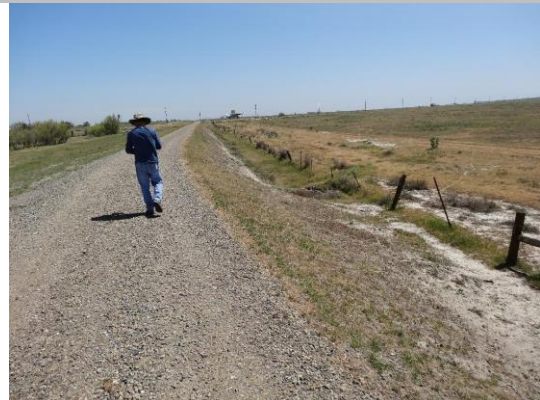
Photo 1 of 3 : UCIP\_SP\_2018\_36584\_66384.jpg

Comment Code						
Inspector Comment						
FS_ID:36584 DS_ID:19822 EP_NO: N/A Repair Type: Non-Urgent Crossing Status: Found UCIP Comments: Dense vegetation limits the inspector's visibility to identify signs of pipe condition on waterward slope and landward toe (headwall blocked by dense vegetation). Recommend removing vegetation from landward toe. FIELD_STRUCT_DESC: 24-inch corrugated metal gravity drainage pipe through the levee, 10.4 feet below the crown. Flap gate on the waterside (WS) end. Concrete headwall on each end. [Additional Reference(s): DWR Levee Log, 2002. USACE San Joaquin O&M Manual 601.1, 1967, (HLM 3.29)]. FS Date: 4/18/2014

Overview of levee crown and landward side.

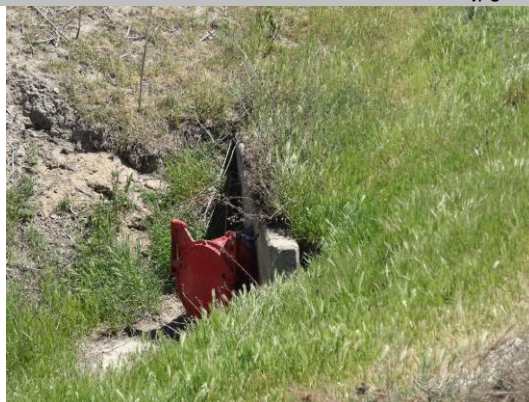
Photo 3 of 3 : UCIP\_SP\_2018\_36584\_66385.jpg

Crossing goes through the levee at an angle. Flap gate visible on waterward side.

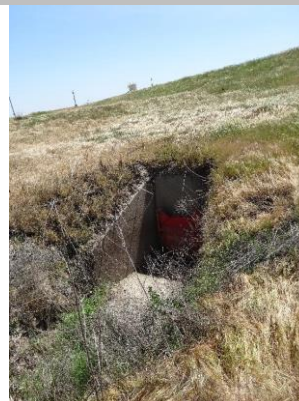
Photo 2 of 3 : UCIP\_SP\_2018\_36585\_66390.jpg

Comment Code					
Inspector Comment					
FS_ID:36585 DS_ID:19823 EP_NO: N/A Repair Type: Non-Urgent Crossing Status: Found UCIP Comments: Alignment of crossing unknown--altered crossing. No headwall found on landward side only siphon breaker found a short distance from landward toe. Tall grass observed on waterward slope and some burrow activity also noticed. Need to contact owner to determine alignment of crossing and status of crossing. FIELD_STRUCT_DESC: 36-inch corrugated metal gravity drainage pipe through the levee, 15.7 feet below the crown. Flap gate on the waterside (WS) end. Concrete U-shaped headwall on each end. Bench mark (BM) stamped 9770-152 on top of the WS headwall. [Additional Reference(s): DWR Levee Log, 2002. USACE San Joaquin O&M Manual 601.1, 1967, (HLM 3.43)]. FS Date: 4/18/2014

Flap gate and concrete headwall visible on waterward side.

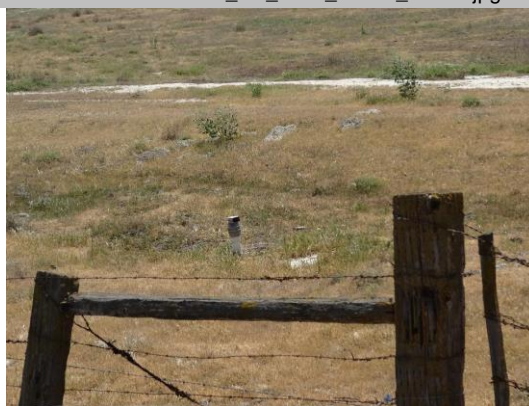
Photo 3 of 3 : UCIP\_SP\_2018\_36585\_66391.jpg

Comment Code						
Inspector Comment						
FS_ID:36585						
DS_ID:19823						
EP_NO: N/A						
Repair Type: Non-Urgent						
Crossing Status: Found						
UCIP Comments: Alignment of crossing unknown--altered crossing. No headwall found on landward side only siphon breaker found a short distance from landward toe. Tall grass observed on waterward slope and some burrow activity also noticed. Need to contact owner to determine alignment of crossing and status of crossing.						
FIELD_STRUCT_DESC: 36-inch corrugated metal gravity drainage pipe through the levee, 15.7 feet below the crown. Flap gate on the waterside (WS) end. Concrete U-shaped headwall on each end. Bench mark (BM) stamped 9770-152 on top of the WS headwall. [Additional Reference(s): DWR Levee Log, 2002. USACE San Joaquin O&M Manual 601.1, 1967, (HLM 3.43)].						
FS Date: 4/18/2014

View of landward side. No signs of concrete headwall only siphon breaker visible on landward side.

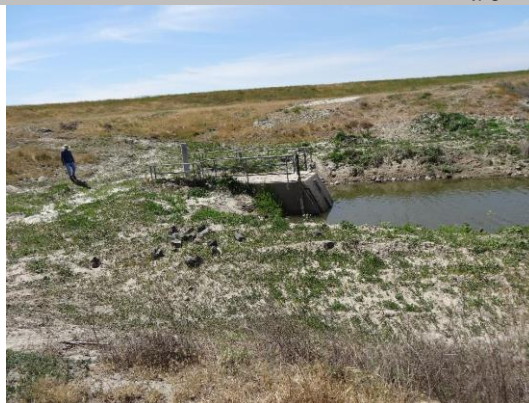
Photo 1 of 3 : UCIP\_SP\_2018\_39482\_71643.jpg

FS\_ID:39482  
DS\_ID:19824  
EP\_NO: 6965  
Repair Type: Non-Urgent  
Crossing Status: Indicator Found  
UCIP Comments: Description of structure does not match. Need to contact owner. Current description includes concrete platform, trash screen, and gage reading on waterward side. Metal box located on waterward shoulder. Large plant facility locate on landward side.  
FIELD\_STRUCT\_DESC: 16-inch coated steel irrigation discharge pipe through the levee, 7.4 feet below the crown. Corrugated metal cutoff wall around the pipe in the center of the levee. Pump on the waterside (WS) with a timber platform on the berm for support. Siphon breaker on the apex of the pipe on the landside (LS) shoulder. Pipe exposed on both slopes. (Plans to place a 20-inch irrigation pipe through the levee authorized under Permit No. 6965, 1971 - Scarborough, Robinson, and Associates). [Additional Reference(s): DWR Levee Log, 2002].

View of structure located on waterward side.

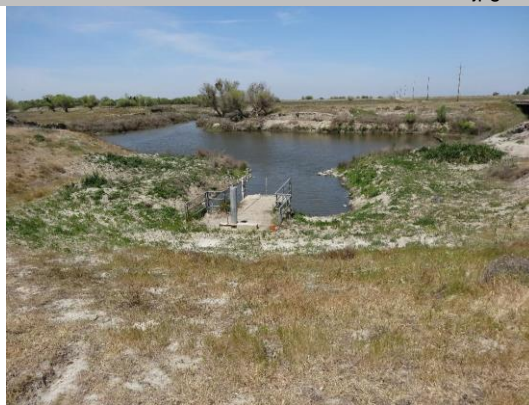
Photo 2 of 3 : UCIP\_SP\_2018\_39482\_71644.jpg

View of waterward side.

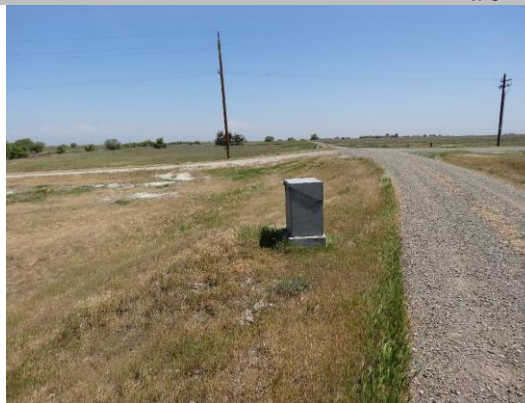
Photo 3 of 3 : UCIP\_SP\_2018\_39482\_71642.jpg

Comment Code						
Inspector Comment						
FS_ID:39482 DS_ID:19824 EP_NO: 6965 Repair Type: Non-Urgent Crossing Status: Indicator Found UCIP Comments: Description of structure does not match. Need to contact owner. Current description includes concrete platform, trash screen, and gage reading on waterward side. Metal box located on waterward shoulder. Large plant facility locate on landward side. FIELD_STRUCT_DESC: 16-inch coated steel irrigation discharge pipe through the levee, 7.4 feet below the crown. Corrugated metal cutoff wall around the pipe in the center of the levee. Pump on the waterside (WS) with a timber platform on the berm for support. Siphon breaker on the apex of the pipe on the landside (LS) shoulder. Pipe exposed on both slopes. (Plans to place a 20-inch irrigation pipe through the levee authorized under Permit No. 6965, 1971 - Scarborough, Robinson, and Associates). [Additional Reference(s): DWR Levee Log, 2002]. FS Date: 4/10/2014

Metal box located on waterward shoulder.

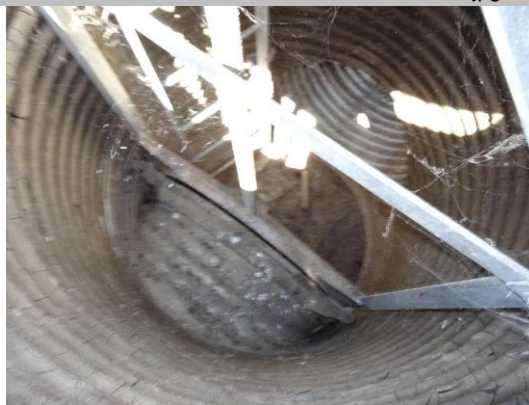
Photo 2 of 3 : UCIP\_SP\_2018\_39465\_66395.jpg

FS\_ID:39465  
DS\_ID:19825  
EP\_NO: N/A  
Repair Type: Non-Urgent  
Crossing Status: Found  
UCIP Comments: Sediment buildup inside pipe visible from landward side. Excess soil is also present on landward toe partially blocking concrete headwall and inlet. Recommend removing soil from landward toe and clear buildup inside.  
FIELD\_STRUCT\_DESC: 36-inch corrugated metal gravity drainage pipe through the levee, 6.8 feet below the crown. Slide gate in a 48-inch corrugated metal pipe (CMP) riser on the waterside (WS) slope. Concrete headwall on each end. Pipe connects to a 30-inch steel drainage pipe on the WS. Drainage pipe extends to the pump on the WS on a support platform in the channel. (Extension drainage pipe and pump installed under Permit No. 12527, 1979 - Joseph Gallo).  
[Additional Reference(s): DWR Levee Log, 2002. USACE San Joaquin O&M Manual 601.1, 1967, (HLM 3.54)].  
FS Date: 4/18/2014

Inside view of cmp riser located on waterward slope.

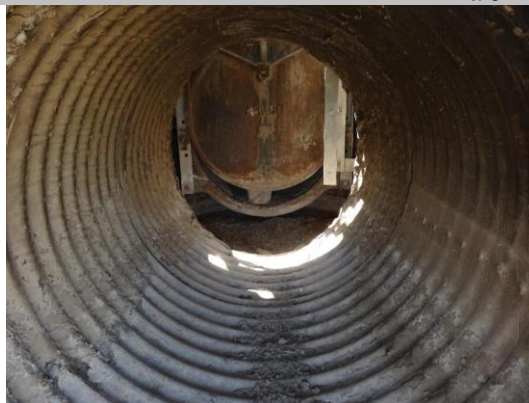
Photo 3 of 3 : UCIP\_SP\_2018\_39465\_66397.jpg

Comment Code						
Inspector Comment						
FS_ID:39465 DS_ID:19825 EP_NO: N/A Repair Type: Non-Urgent Crossing Status: Found UCIP Comments: Sediment buildup inside pipe visible from landward side. Excess soil is also present on landward toe partially blocking concrete headwall and inlet. Recommend removing soil from landward toe and clear buildup inside. FIELD_STRUCT_DESC: 36-inch corrugated metal gravity drainage pipe through the levee, 6.8 feet below the crown. Slide gate in a 48-inch corrugated metal pipe (CMP) riser on the waterside (WS) slope. Concrete headwall on each end. Pipe connects to a 30-inch steel drainage pipe on the WS. Drainage pipe extends to the pump on the WS on a support platform in the channel. (Extension drainage pipe and pump installed under Permit No. 12527, 1979 - Joseph Gallo). [Additional Reference(s): DWR Levee Log, 2002. USACE San Joaquin O&M Manual 601.1, 1967, (HLM 3.54)]. FS Date: 4/18/2014

Inside view of pipe from waterward side.

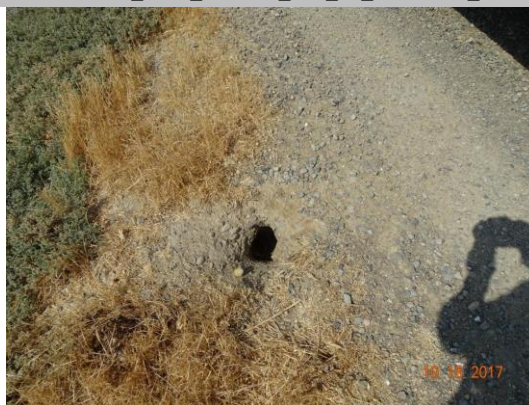
Photo 1 of 1 : SP\_2018\_NA0010\_124\_67\_20180307\_00017.jpg

LM Start	3.49	Rating **	M	Issue No.	67
LM End	3.49	Issue Type +	Ma	Location *	LS
Category	Earthen Levee			GPS Latitude/Longitude	
				Start	End
Item	Animal Control			37.251602 °	37.251602 °
				-120.778118 °	-120.778118 °
DWR ID	DWR_NA0010_06_f_2017_67				
Comment Code					
A1 : Exterminate rodents and backfill and compact or grout burrows.					
Inspector Comment

Looking east at the landside slope.

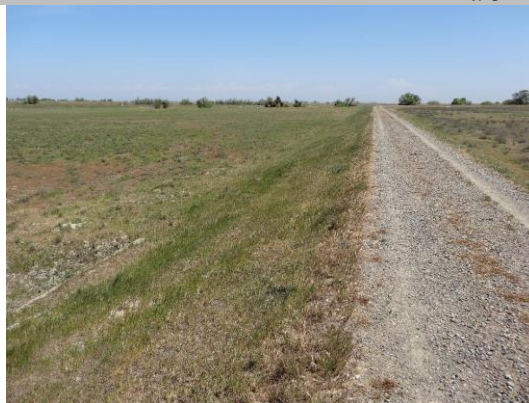
Photo 1 of 3 : UCIP\_SP\_2018\_39466\_66413.jpg

LM Start	3.69	Rating **	M	Issue No.	1224	
LM End	3.69	Issue Type +	Ma	Location *		
Category	Supplemental			GPS Latitude/Longitude		
				Start		End
Item	DWR UCIP LMA Responsibility			37.251199 °		37.251199 °
				-120.774474 °		-120.774474 °
DWR ID						
Comment Code						
Inspector Comment						
FS_ID:39466 DS_ID:19826 EP_NO: N/A Repair Type: Non-Urgent Crossing Status: Found UCIP Comments: Sediment buildup inside crossing and is visible from landward side. Recommend clearing sediment buildup inside pipe and check wall integrity to determine condition. FIELD_STRUCT_DESC: 24-inch corrugated metal gravity drainage pipe through the levee, 7 feet below the crown. Flap gate on the waterside (WS) end. Concrete headwall on each end. [Additional Reference(s): DWR Levee Log, 2002. USACE San Joaquin O&M Manual 601.1, 1967, (HLM 3.77)]. FS Date: 4/18/2014

View of waterward side.

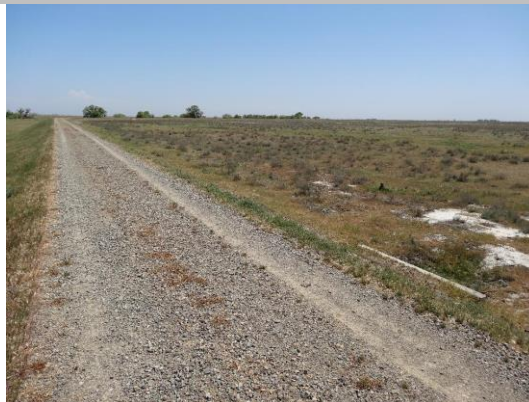
Photo 2 of 3 : UCIP\_SP\_2018\_39466\_66412.jpg

View of landward side.

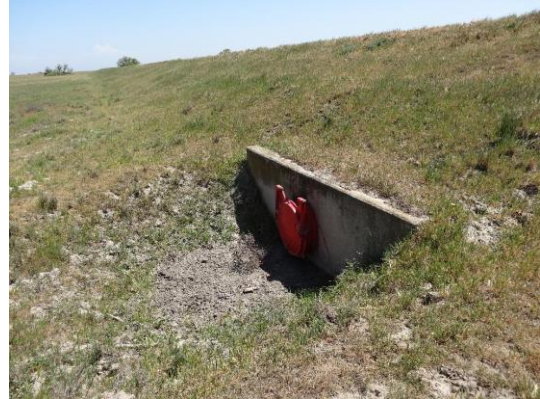
Photo 3 of 3 : UCIP\_SP\_2018\_39466\_66411.jpg

LM Start	3.69	Rating **	M	Issue No.	1224 (cont)
LM End	3.69	Issue Type +	Ma	Location *	
Category	Supplemental			GPS Latitude/Longitude	
				Start	End
Item	DWR UCIP LMA Responsibility			37.251199 °	37.251199 °
				-120.774474 °	-120.774474 °
DWR ID					
Comment Code					
Inspector Comment					
FS_ID:39466 DS_ID:19826 EP_NO: N/A Repair Type: Non-Urgent Crossing Status: Found UCIP Comments: Sediment buildup inside crossing and is visible from landward side. Recommend clearing sediment buildup inside pipe and check wall integrity to determine condition. FIELD_STRUCT_DESC: 24-inch corrugated metal gravity drainage pipe through the levee, 7 feet below the crown. Flap gate on the waterside (WS) end. Concrete headwall on each end. [Additional Reference(s): DWR Levee Log, 2002. USACE San Joaquin O&M Manual 601.1, 1967, (HLM 3.77)]. FS Date: 4/18/2014

View of flap gate visible on waterward side.

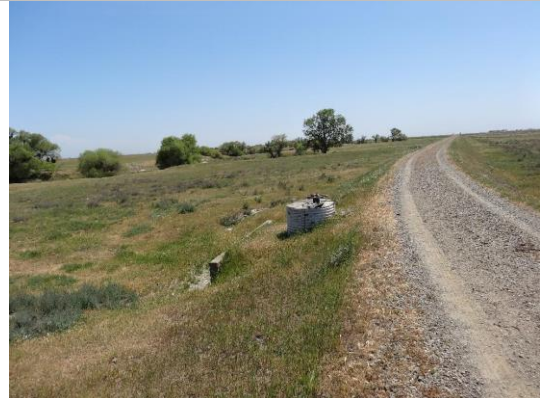
Photo 1 of 3 : UCIP\_SP\_2018\_39467\_66407.jpg

Comment Code					
Inspector Comment					
FS_ID:39467					
DS_ID:19827					
EP_NO: N/A					
Repair Type: Non-Urgent					
Crossing Status: Found					
UCIP Comments: Sediment buildup inside crossing and is visible from landward side. Recommend clearing sediment buildup inside pipe and check wall integrity to determine condition.					
FIELD_STRUCT_DESC: 36-inch corrugated metal gravity drainage pipe through the levee, 6.7 feet below the crown. Slide gate in a 48-inch corrugated metal pipe (CMP) riser on the waterside (WS) slope.					
[Additional Reference(s): DWR Levee Log, 2002. USACE San Joaquin O&M Manual 601.1, 1967, (HLM 3.97)].					
FS Date: 4/18/2014

View of waterward side.

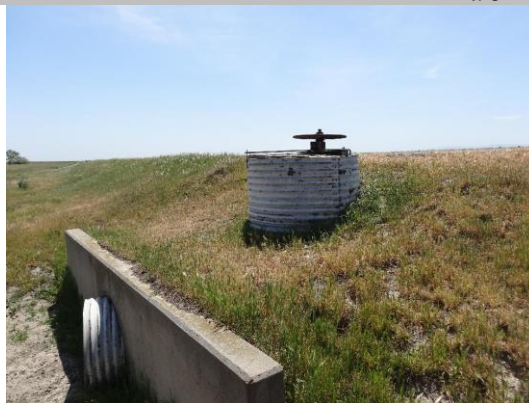
Photo 2 of 3 : UCIP\_SP\_2018\_39467\_66406.jpg

Comment Code						
Inspector Comment						
FS_ID:39467						
DS_ID:19827						
EP_NO: N/A						
Repair Type: Non-Urgent						
Crossing Status: Found						
UCIP Comments: Sediment buildup inside crossing and is visible from landward side. Recommend clearing sediment buildup inside pipe and check wall integrity to determine condition.						
FIELD_STRUCT_DESC: 36-inch corrugated metal gravity drainage pipe through the levee, 6.7 feet below the crown. Slide gate in a 48-inch corrugated metal pipe (CMP) riser on the waterside (WS) slope.						
[Additional Reference(s): DWR Levee Log, 2002. USACE San Joaquin O&M Manual 601.1, 1967, (HLM 3.97)].						
FS Date: 4/18/2014

Slide gate inside CMP riser visible on waterward slope.

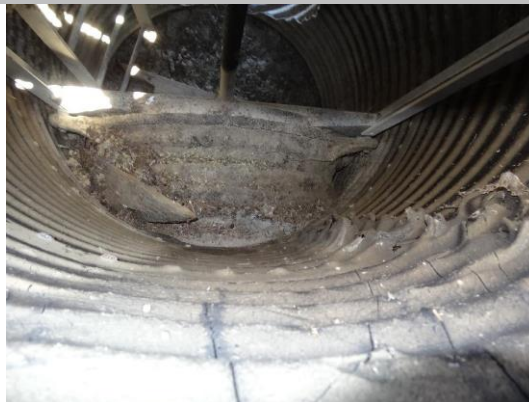
Photo 3 of 3 : UCIP\_SP\_2018\_39467\_66410.jpg

Inside view of CMP riser located on waterward side.

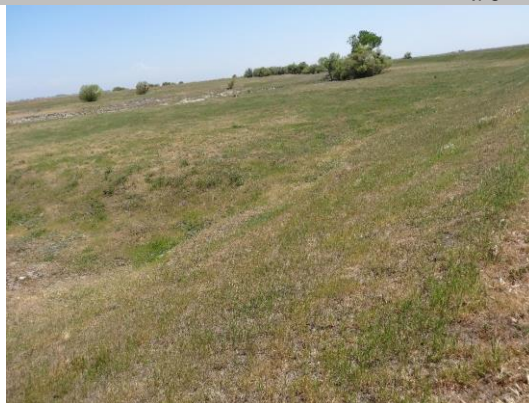
Photo 1 of 3 : UCIP\_SP\_2018\_36606\_66418.jpg

LM Start	4.09	Rating **	M	Issue No.	1226
LM End	4.09	Issue Type +	Ma	Location *	
Category	Supplemental			GPS Latitude/Longitude	
				Start	End
Item	DWR UCIP LMA Responsibility			37.248353 °	37.248353 °
				-120.768922 °	-120.768922 °
DWR ID					
Comment Code					
Inspector Comment					
FS_ID:36606 DS_ID:19828 EP_NO: N/A Repair Type: Non-Urgent Crossing Status: Found UCIP Comments: Dense vegetation limits the inspector's visibility to identify signs of pipe condition on landward toe--headwall blocked by dense vegetation. Recommend removing vegetation from landward toe. FIELD_STRUCT_DESC: 24-inch corrugated metal gravity drainage pipe through the levee, 10.8 feet below the crown. Flap gate on the waterside (WS) end. Concrete headwall on each end. [Additional Reference(s): DWR Levee Log, 2002. USACE San Joaquin O&M Manual 601.1, 1967, (HLM 4.17)]. FS Date: 4/18/2014

View of waterward side.

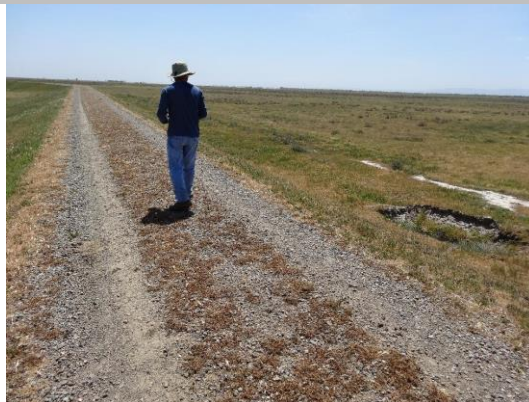
Photo 2 of 3 : UCIP\_SP\_2018\_36606\_66417.jpg

Overview of levee crown at crossing.

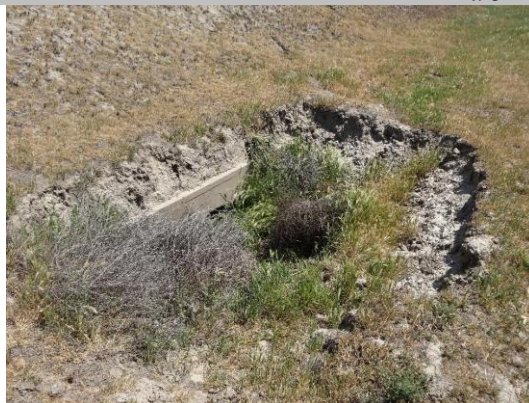
Photo 3 of 3 : UCIP\_SP\_2018\_36606\_66416.jpg

LM Start	4.09	Rating **	M	Issue No.	1226 (cont)	
LM End	4.09	Issue Type +	Ma	Location *		
Category	Supplemental			GPS Latitude/Longitude		
				Start		End
Item	DWR UCIP LMA Responsibility			37.248353 °	37.248353 °	
				-120.768922 °	-120.768922 °	
DWR ID						
Comment Code						
Inspector Comment						
FS_ID:36606 DS_ID:19828 EP_NO: N/A Repair Type: Non-Urgent Crossing Status: Found UCIP Comments: Dense vegetation limits the inspector's visibility to identify signs of pipe condition on landward toe--headwall blocked by dense vegetation. Recommend removing vegetation from landward toe. FIELD_STRUCT_DESC: 24-inch corrugated metal gravity drainage pipe through the levee, 10.8 feet below the crown. Flap gate on the waterside (WS) end. Concrete headwall on each end. [Additional Reference(s): DWR Levee Log, 2002. USACE San Joaquin O&M Manual 601.1, 1967, (HLM 4.17)]. FS Date: 4/18/2014

Concrete headwall visible on landward side.

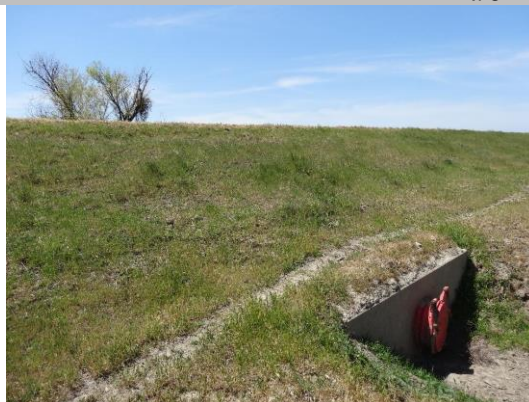
Photo 1 of 2 : UCIP\_SP\_2018\_36607\_66422.jpg

LM Start	4.33	Rating **	M	Issue No.	1227
LM End	4.33	Issue Type +	Ma	Location *	
Category	Supplemental			GPS Latitude/Longitude	
				Start	End
Item	DWR UCIP LMA Responsibility			37.246459 °	37.246459 °
				-120.765470 °	-120.765470 °
DWR ID					
Comment Code					
Inspector Comment					
FS_ID:36607 DS_ID:19829 EP_NO: N/A Repair Type: Non-Urgent Crossing Status: Found UCIP Comments: Dense vegetation limits the inspector's visibility to identify signs of pipe condition on landward toe--headwall blocked by dense vegetation. Recommend removing vegetation from landward toe. FIELD_STRUCT_DESC: 24-inch corrugated metal gravity drainage pipe through the levee, 11.3 feet below the crown. Flap gate on the waterside (WS) end. Concrete headwall on each end. [Additional Reference(s): DWR Levee Log, 2002. USACE San Joaquin O&M Manual 601.1, 1967, (HLM 4.41)]. FS Date: 4/18/2014

View of waterward side--concrete headwall and flap gate visible.

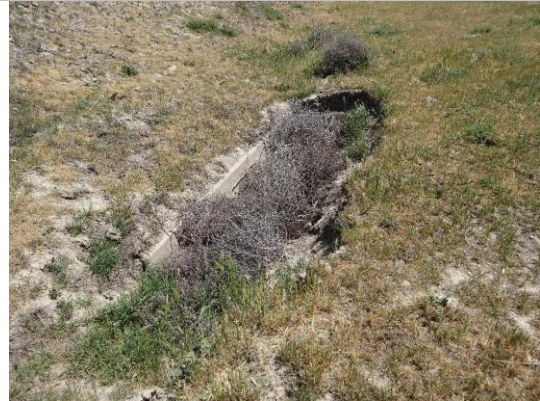
Photo 2 of 2 : UCIP\_SP\_2018\_36607\_66421.jpg

LM Start	4.33	Rating **	M	Issue No.	1227 (cont)	
LM End	4.33	Issue Type +	Ma	Location *		
Category	Supplemental			GPS Latitude/Longitude		
				Start	End	
Item	DWR UCIP LMA Responsibility			37.246459 °	37.246459 °	
				-120.765470 °	-120.765470 °	
DWR ID						
Comment Code						
Inspector Comment						
FS_ID:36607 DS_ID:19829 EP_NO: N/A Repair Type: Non-Urgent Crossing Status: Found UCIP Comments: Dense vegetation limits the inspector's visibility to identify signs of pipe condition on landward toe--headwall blocked by dense vegetation. Recommend removing vegetation from landward toe. FIELD_STRUCT_DESC: 24-inch corrugated metal gravity drainage pipe through the levee, 11.3 feet below the crown. Flap gate on the waterside (WS) end. Concrete headwall on each end. [Additional Reference(s): DWR Levee Log, 2002. USACE San Joaquin O&M Manual 601.1, 1967, (HLM 4.41)]. FS Date: 4/18/2014

View of landward side--concrete headwall visible through dense vegetation.

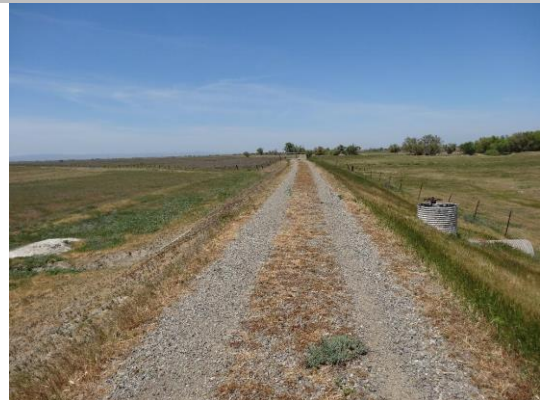
Photo 1 of 3 : UCIP\_SP\_2018\_39468\_66425.jpg

Comment Code						
Inspector Comment						
FS_ID:39468 DS_ID:19830 EP_NO: N/A Repair Type: Non-Urgent Crossing Status: Found UCIP Comments: Sediment buildup inside crossing visible from landward side. Recommend clearing sediment buildup inside pipe and check wall integrity to determine condition. FIELD_STRUCT_DESC: 36-inch corrugated metal gravity drainage pipe through the levee, 6.9 feet below the crown. Slide gate in a 48-inch corrugated metal pipe (CMP) riser on the waterside (WS) slope. Concrete headwall on the landside (LS) end. Concrete saddle and apron on the WS end. [Additional Reference(s): DWR Levee Log, 2002. USACE San Joaquin O&M Manual 601.1, 1967, (HLM 4.70)]. FS Date: 4/18/2014

Overview of levee crown at crossing.

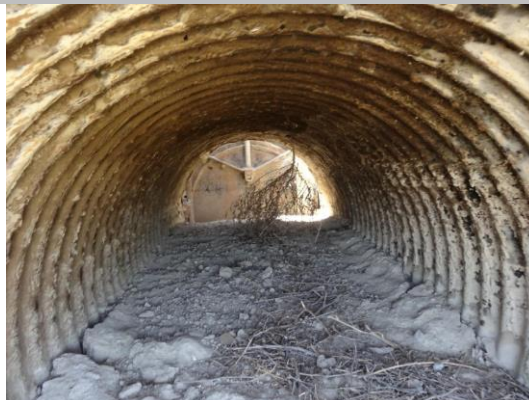
Photo 3 of 3 : UCIP\_SP\_2018\_39468\_66424.jpg

Comment Code						
Inspector Comment						
FS_ID:39468 DS_ID:19830 EP_NO: N/A Repair Type: Non-Urgent Crossing Status: Found UCIP Comments: Sediment buildup inside crossing visible from landward side. Recommend clearing sediment buildup inside pipe and check wall integrity to determine condition. FIELD_STRUCT_DESC: 36-inch corrugated metal gravity drainage pipe through the levee, 6.9 feet below the crown. Slide gate in a 48-inch corrugated metal pipe (CMP) riser on the waterside (WS) slope. Concrete headwall on the landside (LS) end. Concrete saddle and apron on the WS end. [Additional Reference(s): DWR Levee Log, 2002. USACE San Joaquin O&M Manual 601.1, 1967, (HLM 4.70)]. FS Date: 4/18/2014

Inside view of pipe from waterward side.

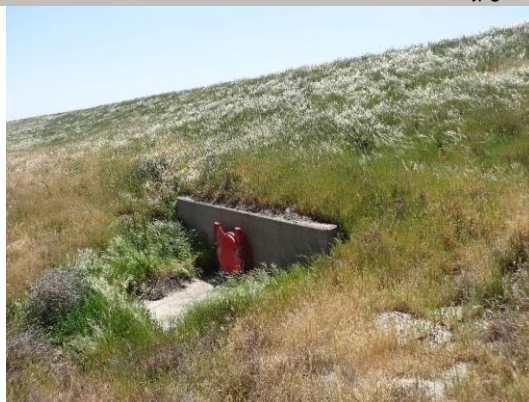
Photo 2 of 3 : UCIP\_SP\_2018\_36609\_66432.jpg

Flap gate, concrete headwall and apron visible on waterward toe.

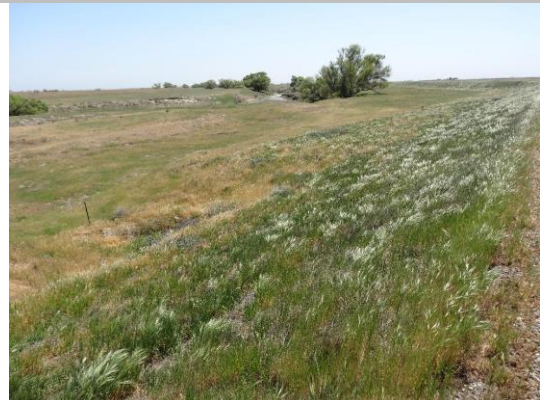
Photo 1 of 3 : UCIP\_SP\_2018\_36610\_66436.jpg

Comment Code					
Inspector Comment					
FS_ID:36610 DS_ID:19862 EP_NO: N/A Repair Type: Non-Urgent Crossing Status: Found UCIP Comments: Dense vegetation limits the inspector's visibility to identify signs of pipe failure (leaks) along the waterward slope. Recommend removing vegetation along waterward slope to conduct proper inspection of structure. Also recommend removing dense vegetation blocking landward headwall. FIELD_STRUCT_DESC: 24-inch corrugated metal gravity drainage pipe through the levee, 10.8 feet below the crown. Flap gate on the waterside (WS) end. Concrete headwall on each end. [Additional Reference(s): DWR Levee Log, 2002. USACE San Joaquin O&M Manual 601.1, 1967, (HLM 4.94)]. FS Date: 4/18/2014

View of waterward side.

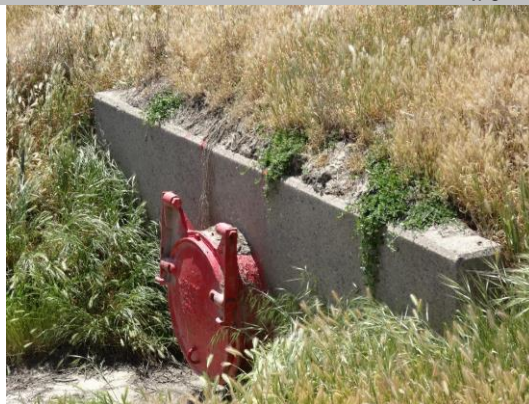
Photo 3 of 3 : UCIP\_SP\_2018\_36610\_66437.jpg

Close up of flap gate located on waterward side.

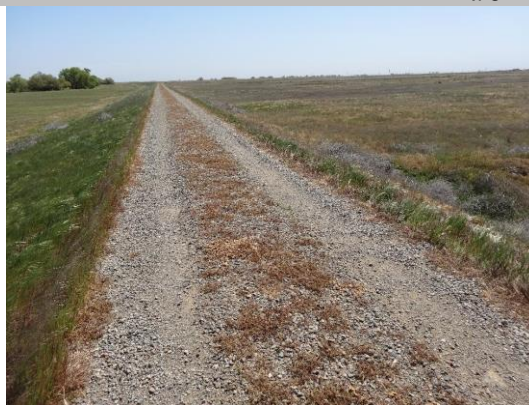
Photo 2 of 3 : UCIP\_SP\_2018\_39875\_61598.jpg

Overview of levee crown at crossing.

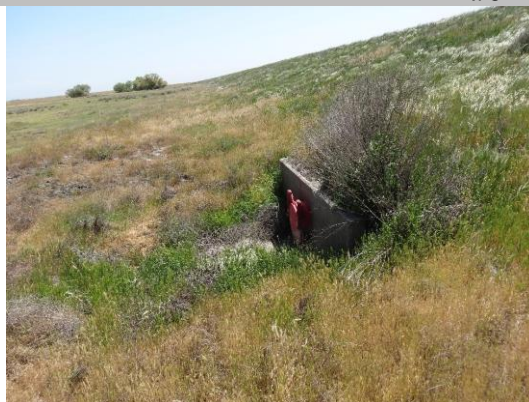
Photo 1 of 3 : UCIP\_SP\_2018\_36611\_66441.jpg

Comment Code					
Inspector Comment					
FS_ID:36611 DS_ID:19864 EP_NO: N/A Repair Type: Non-Urgent Crossing Status: Found UCIP Comments: Dense vegetation limits the inspector's visibility to identify signs of pipe failure (leaks) along the waterward slope. Recommend removing vegetation along pipe alignment to conduct proper inspection of structure. Also recommend removing excess vegetation at landward headwall. FIELD_STRUCT_DESC: 24-inch corrugated metal gravity drainage pipe through the levee, 11 feet below the crown. Flap gate on the waterside (WS) end. Concrete headwall on each end. [Additional Reference(s): DWR Levee Log, 2002. USACE San Joaquin O&M Manual 601.1, 1967, (HLM 5.63)]. FS Date: 4/18/2014

Concrete headwall and flap gate visible on waterward toe.

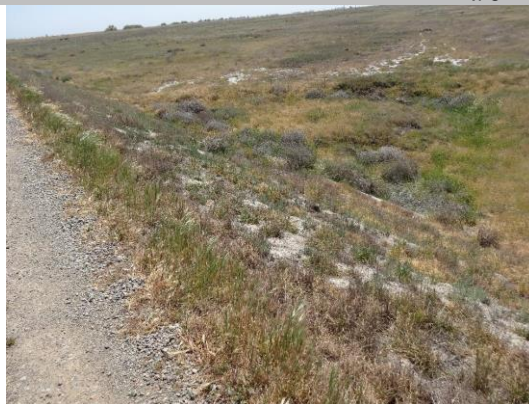
Photo 3 of 3 : UCIP\_SP\_2018\_36611\_66439.jpg

View of landward side.

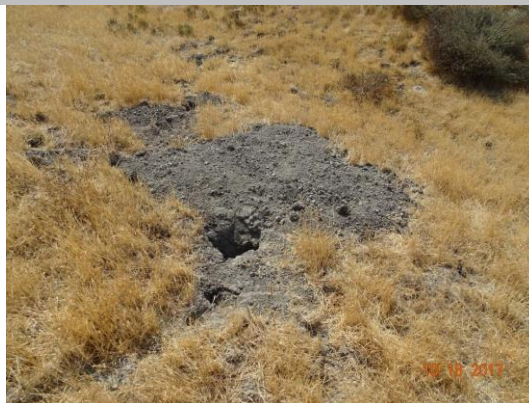
Photo 1 of 1 : SP\_2018\_NA0010\_124\_66\_20180307\_00016.jpg

LM Start	5.81	Rating **	U	Issue No.	66
LM End	5.81	Issue Type +	Ma	Location *	LS
Category	Earthen Levee			GPS Latitude/Longitude	
				Start	End
Item	Animal Control			37.238189 °	37.238189 °
				-120.741946 °	-120.741946 °
DWR ID	DWR_NA0010_06_f_2017_66				
Comment Code					
A3 : No rodents visible, but rodent burrows visible; need to backfill and compact or grout burrows.					
Inspector Comment

Looking southwest at the landside slope.

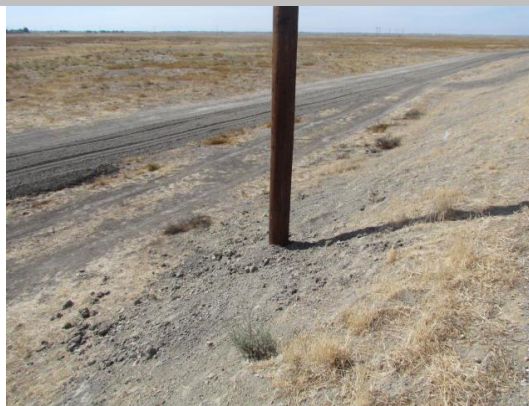
Photo 1 of 2 : SP\_2018\_NA0010\_124\_69\_20180307\_00019.jpg

LM Start	5.93	Rating **	U	Issue No.	69
LM End	6.25	Issue Type +	En	Location *	LS
Category	Earthen Levee			GPS Latitude/Longitude	
				Start	End
Item	Encroachments			37.236936 °	37.235487 °
				-120.740384 °	-120.737685 °
DWR ID	DWR_NA0010_06_f_2015_69				
Comment Code					
PO : Pole					
Inspector Comment					
Several PG& E poles within this section at the landside toe and slope.

Looking at power pole on landward slope.

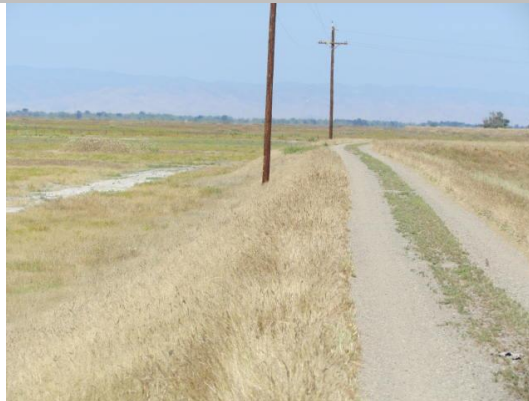
Photo 2 of 2 : SP\_2018\_NA0010\_124\_69\_20180307\_00020.jpg

Looking west at several PG&amp;E poles on landward slope.

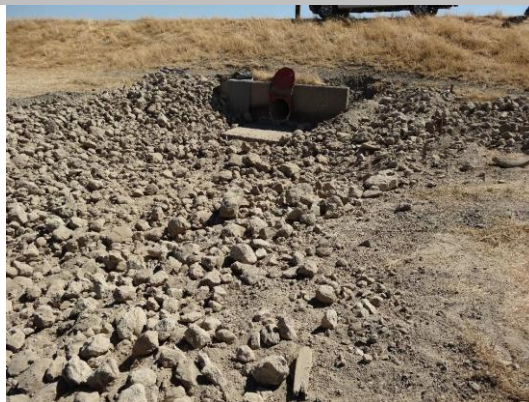
Photo 2 of 3 : UCIP\_SP\_2018\_51312\_75488.jpg

WS drainage path protected by rip rap.

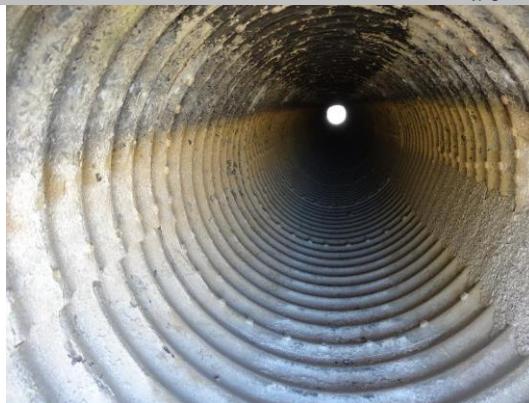
Photo 3 of 3 : UCIP\_SP\_2018\_51312\_75489.jpg

Inside view of pipe from WS.

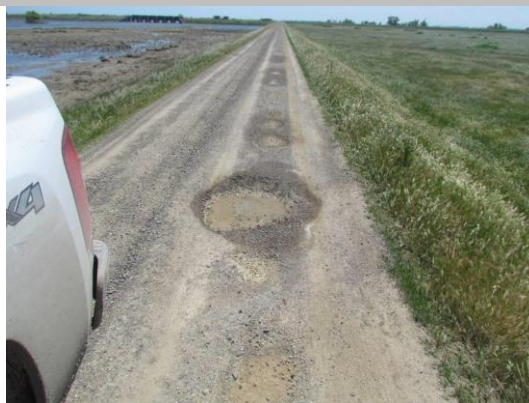
Photo 1 of 2 : SP\_2018\_NA0010\_124\_6\_20180307\_00010.jpg

LM Start	6.44	Rating **	M	Issue No.	6
LM End	11.00	Issue Type +	Ma	Location *	CR
Category	Earthen Levee			GPS Latitude/Longitude	
				Start	End
Item	Crown Surface / Depressions / Rutting			37.233587 °	37.187645 °
				-120.732480 °	-120.676996 °
DWR ID	DWR_NA0010_06_s _ 2012_6				
Comment Code					
C2 : Repair depressions or ruts in the crown or slope.					
Inspector Comment					
Levee crown should be regraded due to excessive rutting and potholes on levee crown..

Looking upstream at large pot hole on levee crown.

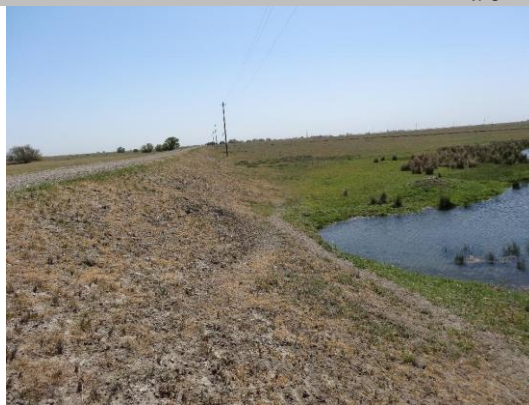
Photo 3 of 3 : UCIP\_SP\_2018\_33985\_61638.jpg

View of landward side.
