**Flood Control Project Maintenance  
Levee Inspections**  
**LMA District Cover Sheet**  
**Spring 2018 Levee Inspection Results**

**Lower San Joaquin Levee District**

**Spring 2018 Levee Inspection Results**

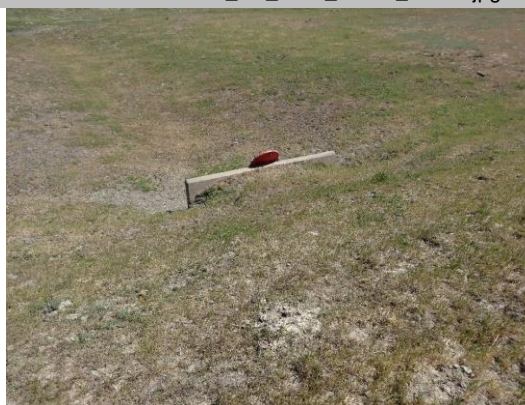
Photo 1 of 3 : UCIP\_SP\_2018\_39471\_61650.jpg

LM Start	7.21	Rating **	M	Issue No.	1236
LM End	7.21	Issue Type +	Ma	Location *	
Category	Supplemental			GPS Latitude/Longitude	
				Start	End
Item	DWR UCIP LMA Responsibility			37.226102 °	37.226102 °
				-120.722739 °	-120.722739 °
DWR ID					
Comment Code					
Inspector Comment					
FS_ID:39471 DS_ID:19868 EP_NO: N/A Repair Type: Non-Urgent Crossing Status: Found UCIP Comments: Need to contact owner. Clear animal from waterward side. Some sediment buildup in pipe visible landward side--recommend clearing. FIELD_STRUCT_DESC: 24-inch corrugated metal gravity drainage pipe through the levee, 10.6 feet below the crown. Flap gate on the waterside (WS) end. Concrete headwall on each end. [Additional Reference(s): DWR Levee Log, 2002. USACE San Joaquin O&M Manual 601.1, 1967, (HLM 7.29)]. FS Date: 4/18/2014

View of waterward side.

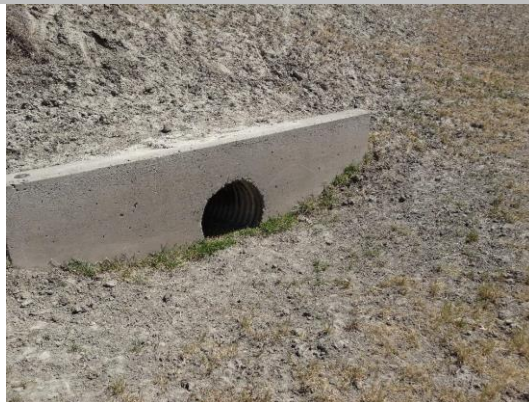
Photo 3 of 3 : UCIP\_SP\_2018\_39471\_61648.jpg

View of landward side.

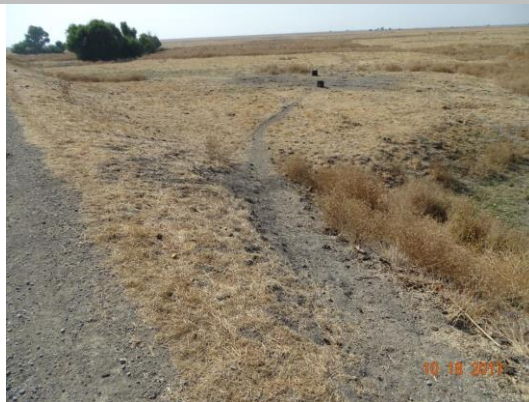
Photo 1 of 1 : SP\_2018\_NA0010\_124\_65\_20180307\_00015.jpg

LM Start	8.08	Rating **	M	Issue No.	65
LM End	8.08	Issue Type +	Ma	Location *	LS
Category	Earthen Levee			GPS Latitude/Longitude	
				Start	End
Item	Slope Stability			37.217199 °	37.217199 °
				-120.713374 °	-120.713374 °
DWR ID	DWR_NA0010_06_f_2017_65				
Comment Code					
S2 : Repair the levee slope damaged by foot traffic and prevent access where possible.					
Inspector Comment

Looking southwest at the landside slope.

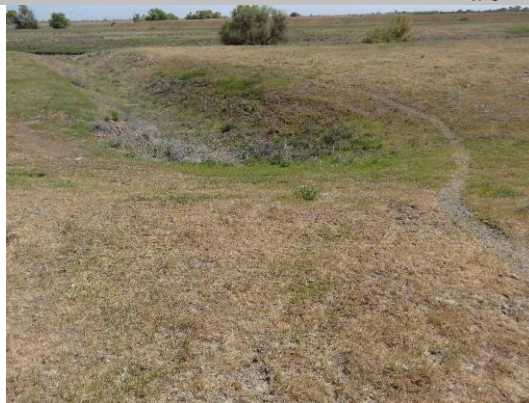
Photo 1 of 3 : UCIP\_SP\_2018\_39473\_61674.jpg

LM Start	8.13	Rating **	M	Issue No.	1238
LM End	8.13	Issue Type +	Ma	Location *	
Category	Supplemental			GPS Latitude/Longitude	
				Start	End
Item	DWR UCIP LMA Responsibility			37.216547 °	37.216547 °
				-120.713000 °	-120.713000 °
DWR ID					
Comment Code					
Inspector Comment					
FS_ID:39473 DS_ID:19870 EP_NO: N/A Repair Type: Non-Urgent Crossing Status: Found UCIP Comments: Sediment buildup in pipe--recommend contacting owner to clear sediment. FIELD_STRUCT_DESC: 24-inch corrugated metal gravity drainage pipe through the levee, 16.5 feet below the crown. Flap gate on the waterside (WS) end. Concrete headwall on each end. [Additional Reference(s): DWR Levee Log, 2002. USACE San Joaquin O&M Manual 601.1, 1967, (HLM 8.21)]. FS Date: 4/18/2014

View of waterward side.

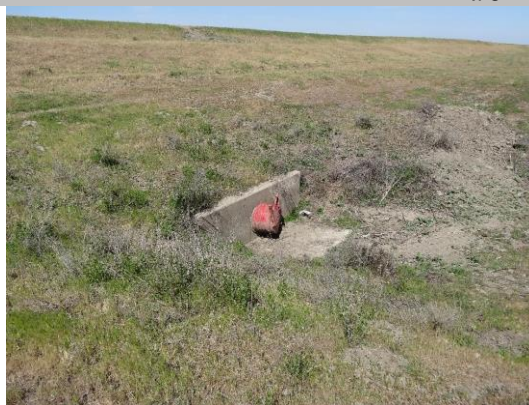
Photo 2 of 3 : UCIP\_SP\_2018\_39473\_61673.jpg

Pipe crosses levee at an angle.

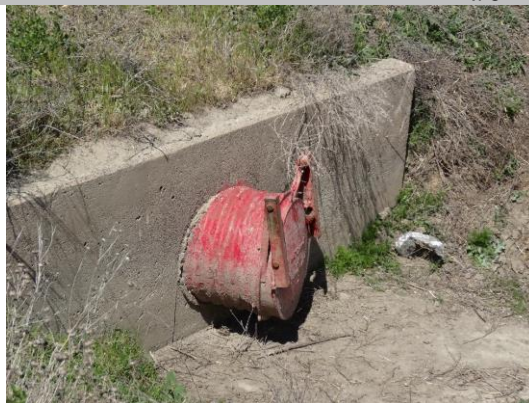
Photo 3 of 3 : UCIP\_SP\_2018\_39473\_61672.jpg

LM Start	8.13	Rating **	M	Issue No.	1238 (cont)	
LM End	8.13	Issue Type +	Ma	Location *		
Category	Supplemental			GPS Latitude/Longitude		
				Start		End
Item	DWR UCIP LMA Responsibility			37.216547 °		37.216547 °
				-120.713000 °		-120.713000 °
DWR ID						
Comment Code						
Inspector Comment						
FS_ID:39473 DS_ID:19870 EP_NO: N/A Repair Type: Non-Urgent Crossing Status: Found UCIP Comments: Sediment buildup in pipe--recommend contacting owner to clear sediment. FIELD_STRUCT_DESC: 24-inch corrugated metal gravity drainage pipe through the levee, 16.5 feet below the crown. Flap gate on the waterside (WS) end. Concrete headwall on each end. [Additional Reference(s): DWR Levee Log, 2002. USACE San Joaquin O&M Manual 601.1, 1967, (HLM 8.21)]. FS Date: 4/18/2014

Concrete headwall and flap gate visible on waterward side.

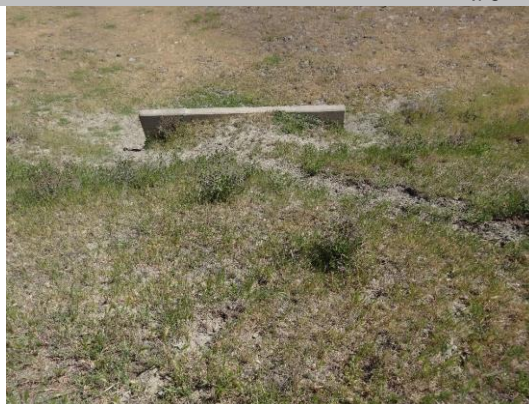
Photo 1 of 3 : UCIP\_SP\_2018\_39474\_61685.jpg

Comment Code						
Inspector Comment						
FS_ID:39474 DS_ID:19871 EP_NO: N/A Repair Type: Non-Urgent Crossing Status: Found UCIP Comments: Need to contact owner. Sediment buildup in pipe visible on landward side--recommend clearing. Good candidate for pressure test or video inspection due to signs of heavy corrosion. If no leaks after tests this crossing would be a good candidate for rehabilitation. FIELD_STRUCT_DESC: 24-inch corrugated metal gravity drainage pipe through the levee, 9.2 feet below the crown. Flap gate on the waterside (WS) end. Concrete headwall on each end. [Additional Reference(s): DWR Levee Log, 2002. USACE San Joaquin O&M Manual 601.1, 1967, (HLM 8.51)]. FS Date: 4/18/2014

View of waterward side.

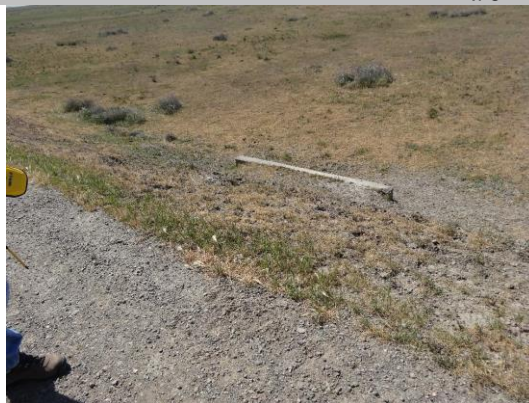
Photo 2 of 3 : UCIP\_SP\_2018\_39474\_61684.jpg

Comment Code					
Inspector Comment					
FS_ID:39474 DS_ID:19871 EP_NO: N/A Repair Type: Non-Urgent Crossing Status: Found UCIP Comments: Need to contact owner. Sediment buildup in pipe visible on landward side--recommend clearing. Good candidate for pressure test or video inspection due to signs of heavy corrosion. If no leaks after tests this crossing would be a good candidate for rehabilitation. FIELD_STRUCT_DESC: 24-inch corrugated metal gravity drainage pipe through the levee, 9.2 feet below the crown. Flap gate on the waterside (WS) end. Concrete headwall on each end. [Additional Reference(s): DWR Levee Log, 2002. USACE San Joaquin O&M Manual 601.1, 1967, (HLM 8.51)]. FS Date: 4/18/2014

View of landward side.

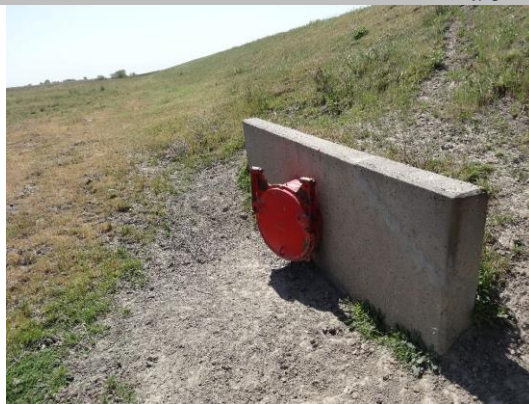
Photo 3 of 3 : UCIP\_SP\_2018\_39474\_61683.jpg

Pipe crosses levee at an angle.

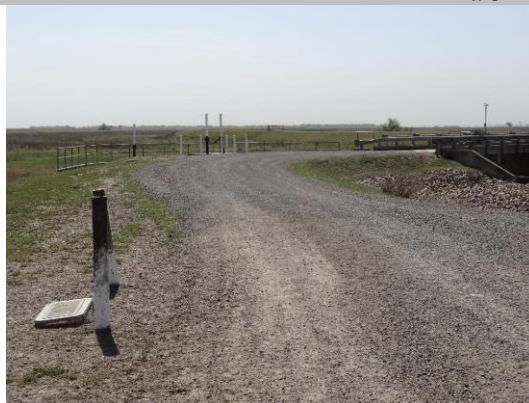
Photo 1 of 2 : UCIP\_SP\_2018\_42525\_72925.jpg

LM Start	9.52	Rating **	M	Issue No.	1240
LM End	9.52	Issue Type +	En	Location *	
Category	Supplemental			GPS Latitude/Longitude	
				Start	End
Item	DWR UCIP Field Study			37.202481 °	37.202481 °
				-120.695303 °	-120.695303 °
DWR ID					
Comment Code					
Inspector Comment					
FS_ID:42525 DS_ID:19872 EP_NO: N/A Repair Type: Non-Urgent Crossing Status: Indicator Found UCIP Comments: 12/5/14 Accidentally missed updating record. Photos have been added and coordinates have been updated. Unable to confirm if crossing is the same cable line originally identified in desk study at levee mile 6.43. Recommend contacting owner to confirm alignment, size of conduit, and permit issued. FIELD_STRUCT_DESC: Telephone cable of an unknown size or material under crown of roadway, at an unknown depth. [Additional Reference(s): DWR Levee Log, 2002]. FS Date: 4/18/2014

Service box located on waterward levee shoulder.

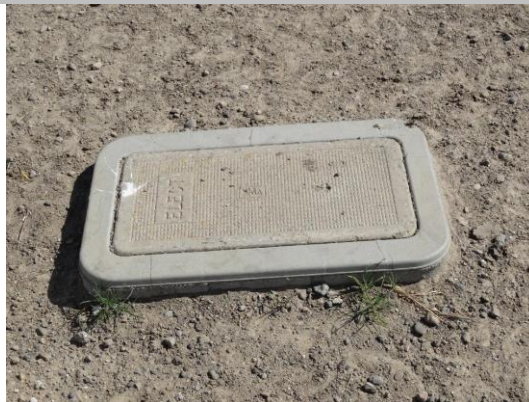
Photo 2 of 2 : UCIP\_SP\_2018\_42525\_72924.jpg

Service box is for electrical conduit.

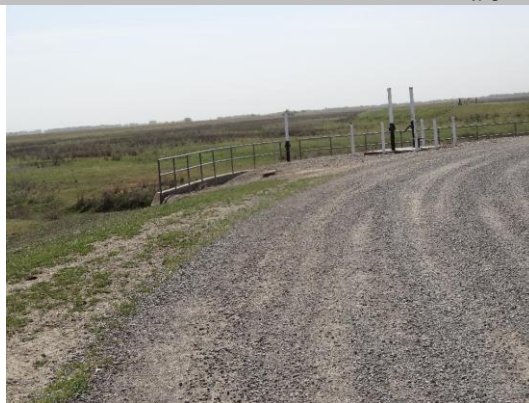
Photo 1 of 3 : UCIP\_SP\_2018\_42524\_72922.jpg

LM Start	9.56	Rating **	M	Issue No.	1241
LM End	9.56	Issue Type +	En	Location *	
Category	Supplemental			GPS Latitude/Longitude	
				Start	End
Item	DWR UCIP Field Study			37.202014 °	37.202014 °
				-120.694820 °	-120.694820 °
DWR ID					
Comment Code					
Inspector Comment					
FS_ID:42524 DS_ID:19873 EP_NO: N/A Repair Type: Non-Urgent Crossing Status: Found UCIP Comments: 12/5/14 Accidently missed entry. Photos have been added and coordinates have been updated by Olivia Magana. Unable to determine condition of crossing due to limited access. Recommend contacting owner to provide condition of crossing. FIELD_STRUCT_DESC: 36-inch corrugated metal gravity drainage pipe through the levee, 14 feet below the crown. Slide gate in a concrete diversion box on the waterside (WS) shoulder. [Additional Reference(s): DWR Levee Log, 2002]. FS Date: 4/18/2014

Overview of levee crown looking upstream.

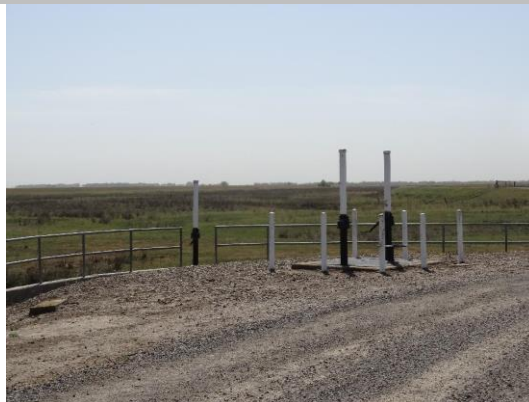
Photo 2 of 3 : UCIP\_SP\_2018\_42524\_72921.jpg

Concrete box located on waterward side.

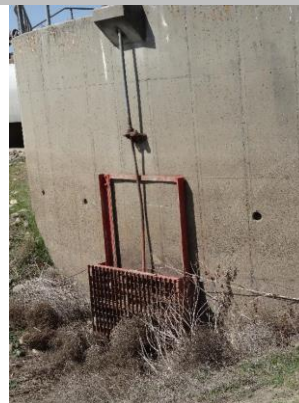
Photo 3 of 3 : UCIP\_SP\_2018\_42524\_72920.jpg

LM Start	9.56	Rating **	M	Issue No.	1241 (cont)	
LM End	9.56	Issue Type +	En	Location *		
Category	Supplemental			GPS Latitude/Longitude		
				Start		End
Item	DWR UCIP Field Study			37.202014 °		37.202014 °
				-120.694820 °		-120.694820 °
DWR ID						
Comment Code						
Inspector Comment						
FS_ID:42524 DS_ID:19873 EP_NO: N/A Repair Type: Non-Urgent Crossing Status: Found UCIP Comments: 12/5/14 Accidently missed entry. Photos have been added and coordinates have been updated by Olivia Magana. Unable to determine condition of crossing due to limited access. Recommend contacting owner to provide condition of crossing. FIELD_STRUCT_DESC: 36-inch corrugated metal gravity drainage pipe through the levee, 14 feet below the crown. Slide gate in a concrete diversion box on the waterside (WS) shoulder. [Additional Reference(s): DWR Levee Log, 2002]. FS Date: 4/18/2014

Trash gate visible on waterward side.

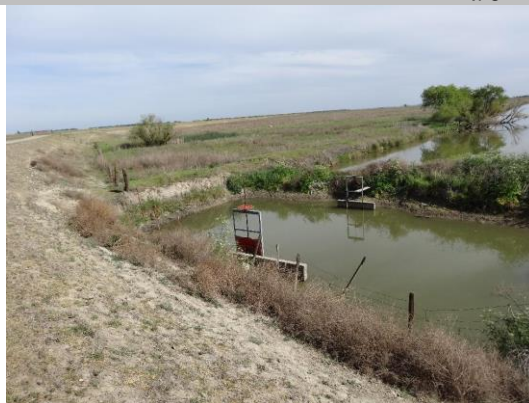
Photo 1 of 2 : UCIP\_SP\_2018\_39475\_61691.jpg

LM Start	9.66	Rating **	M	Issue No.	1247	
LM End	9.66	Issue Type +	En	Location *		
Category	Supplemental			GPS Latitude/Longitude		
				Start	End	
Item	DWR UCIP Field Study			37.200948 °	37.200948 °	
				-120.694362 °	-120.694362 °	
DWR ID						
Comment Code						
Inspector Comment						
FS_ID:39475						
DS_ID:19874						
EP_NO: N/A						
Repair Type: Non-Urgent						
Crossing Status: Found						
UCIP Comments: Waterward side not visible--need to determine alignment.						
FIELD_STRUCT_DESC: 36-inch corrugated metal gravity drainage pipe through the levee, 14 feet below the crown. Slide gate in a concrete diversion box on the waterside (WS) shoulder. [Additional Reference(s): DWR Levee Log, 2002].						
FS Date: 4/17/2014

View of landward side.

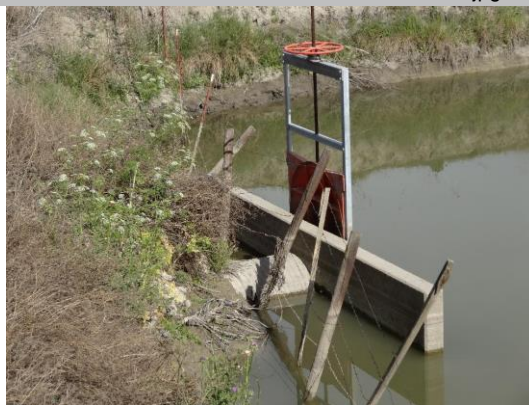
Photo 2 of 2 : UCIP\_SP\_2018\_39475\_61690.jpg

Pipe, slide gate, and concrete headwall visible on landward side.

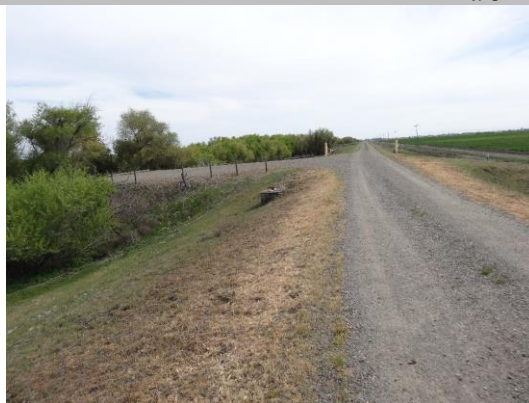
Photo 1 of 3 : UCIP\_SP\_2018\_39476\_66488.jpg

LM Start	11.74	Rating **	M	Issue No.	1249
LM End	11.74	Issue Type +	Ma	Location *	
Category	Supplemental			GPS Latitude/Longitude	
				Start	End
Item	DWR UCIP LMA Responsibility			37.185513 °	37.185513 °
				-120.664561 °	-120.664561 °
DWR ID					
Comment Code					
Inspector Comment					
FS_ID:39476					
DS_ID:19876					
EP_NO: N/A					
Repair Type: Non-Urgent					
Crossing Status: Found					
UCIP Comments: Clear debris from waterward and landward toes.					
FIELD_STRUCT_DESC: 36-inch corrugated metal gravity drainage pipe					
through the levee, 17 feet below the crown. Slide gate in a pipe riser on					
the waterside (WS) slope. [Additional Reference(s): DWR Levee Log,					
2002. USACE San Joaquin O&M Manual 601.1, 1967, (HLM 11.82)].					
FS Date: 4/17/2014

View of waterward side.

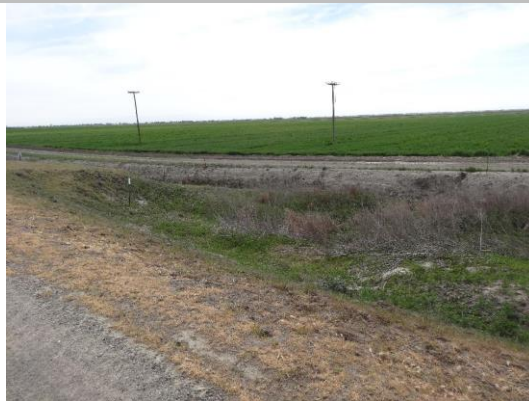
Photo 2 of 3 : UCIP\_SP\_2018\_39476\_66487.jpg

View of landward side.

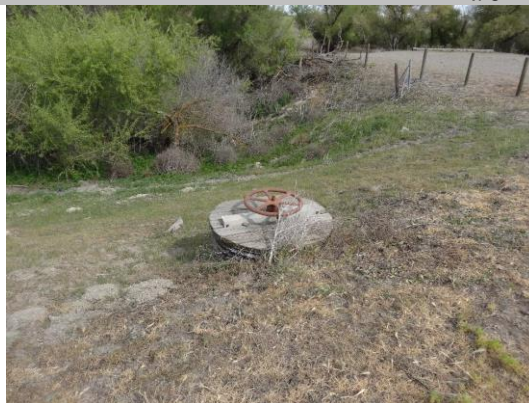
Photo 3 of 3 : UCIP\_SP\_2018\_39476\_66486.jpg

LM Start	11.74	Rating **	M	Issue No.	1249 (cont)	
LM End	11.74	Issue Type +	Ma	Location *		
Category	Supplemental			GPS Latitude/Longitude		
				Start	End	
Item	DWR UCIP LMA Responsibility			37.185513 °	37.185513 °	
				-120.664561 °	-120.664561 °	
DWR ID						
Comment Code						
Inspector Comment						
FS_ID:39476						
DS_ID:19876						
EP_NO: N/A						
Repair Type: Non-Urgent						
Crossing Status: Found						
UCIP Comments: Clear debris from waterward and landward toes.						
FIELD_STRUCT_DESC: 36-inch corrugated metal gravity drainage pipe						
through the levee, 17 feet below the crown. Slide gate in a pipe riser on						
the waterside (WS) slope. [Additional Reference(s): DWR Levee Log,						
2002. USACE San Joaquin O&M Manual 601.1, 1967, (HLM 11.82)].						
FS Date: 4/17/2014

Slide gate inside CMP riser located on waterward slope.

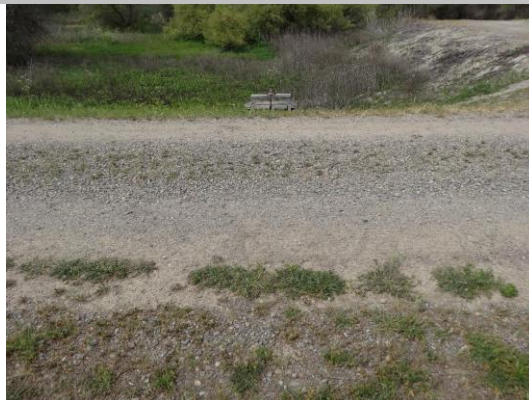
Photo 1 of 3 : UCIP\_SP\_2018\_39477\_66492.jpg

LM Start	13.22	Rating **	M	Issue No.	1250
LM End	13.22	Issue Type +	Ma	Location *	
Category	Supplemental			GPS Latitude/Longitude	
				Start	End
Item	DWR UCIP LMA Responsibility			37.171675 °	37.171675 °
				-120.655064 °	-120.655064 °
DWR ID					
Comment Code					
Inspector Comment					
FS_ID:39477					
DS_ID:19877					
EP_NO: N/A					
Repair Type: Non-Urgent					
Crossing Status: Found					
UCIP Comments: Not accessible--crossing is buried on landward side.					
Need to contact owner to determine status.					
FIELD_STRUCT_DESC: 24-inch corrugated metal gravity drainage pipe					
through the levee, 10.8 feet below the crown. Flap gate on the					
waterside (WS) end. [Additional Reference(s): DWR Levee Log, 2002.					
USACE San Joaquin O&M Manual 601.1, 1967, (HLM 13.30)].					
FS Date: 4/17/2014

View of levee crown at crossing.

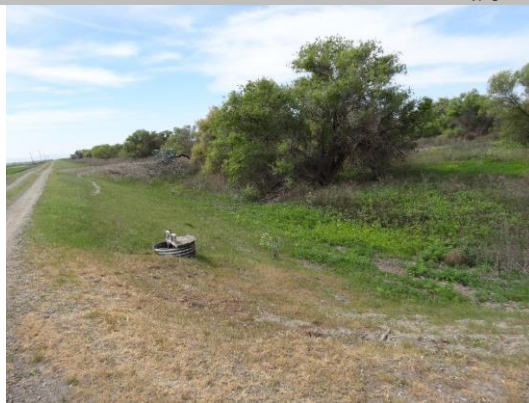
Photo 2 of 3 : UCIP\_SP\_2018\_39477\_66494.jpg

LM Start	13.22	Rating **	M	Issue No.	1250 (cont)
LM End	13.22	Issue Type +	Ma	Location *	
Category	Supplemental			GPS Latitude/Longitude	
				Start	End
Item	DWR UCIP LMA Responsibility			37.171675 °	37.171675 °
				-120.655064 °	-120.655064 °
DWR ID					
Comment Code					
Inspector Comment					
FS_ID:39477					
DS_ID:19877					
EP_NO: N/A					
Repair Type: Non-Urgent					
Crossing Status: Found					
UCIP Comments: Not accessible--crossing is buried on landward side.					
Need to contact owner to determine status.					
FIELD_STRUCT_DESC: 24-inch corrugated metal gravity drainage pipe					
through the levee, 10.8 feet below the crown. Flap gate on the					
waterside (WS) end. [Additional Reference(s): DWR Levee Log, 2002.					
USACE San Joaquin O&M Manual 601.1, 1967, (HLM 13.30)].					
FS Date: 4/17/2014

View of waterward slope.

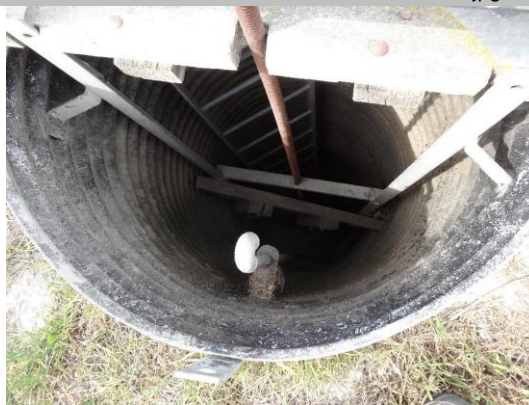
Photo 3 of 3 : UCIP\_SP\_2018\_39477\_66495.jpg

Inside view of CMP riser located on waterward slope.

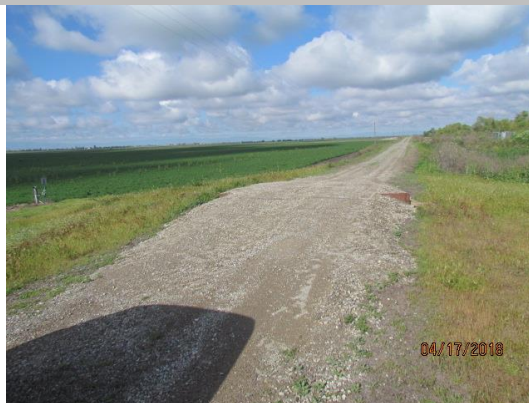
Photo 1 of 2 : SP\_2018\_NA0010\_124\_88\_20180420\_00179.jpg

LM Start	13.23	Rating **	U	Issue No.	88
LM End	13.23	Issue Type +	En	Location *	CR
Category	Earthen Levee			GPS Latitude/Longitude	
				Start	End
Item	Encroachments			37.171678 °	37.171678 °
				-120.654920 °	-120.654920 °
DWR ID	DWR_NA0010_06_s_2018_88				
Comment Code					
PI : Pipe					
Inspector Comment					
Landowner or Farmer installed a 3-4 inch pipe across levee crown.

Looking north at pipe across levee crown. (Spring 2018)

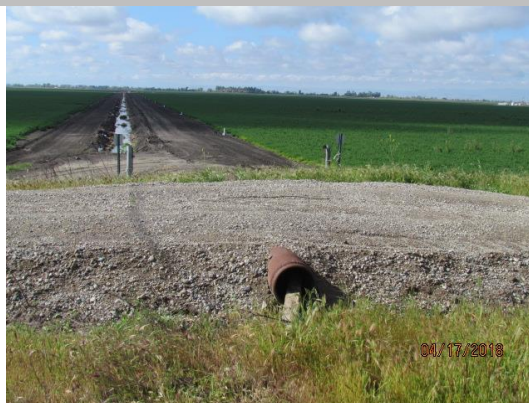
Photo 2 of 2 : SP\_2018\_NA0010\_124\_88\_20180420\_00180.jpg

Looking east at pipe across levee crown. (Spring 2018)

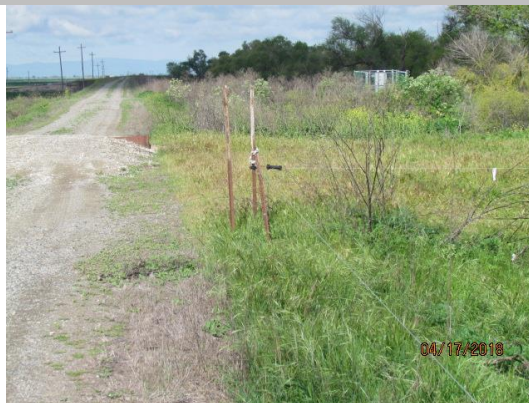
Photo 1 of 2 : SP\_2018\_NA0010\_124\_89\_20180420\_00181.jpg

LM Start	13.24	Rating **	M	Issue No.	89
LM End	15.66	Issue Type +	En	Location *	WS
Category	Earthen Levee			GPS Latitude/Longitude	
				Start	End
Item	Encroachments			37.171680 °	37.157145 °
				-120.654574 °	-120.617501 °
DWR ID	DWR_NA0010_06_s_2018_89				
Comment Code					
FE : Fence					
Inspector Comment					
Electric fence installed on waterward shoulder.

Looking south at the start of electric fence on waterward shoulder. (Spring 2018)

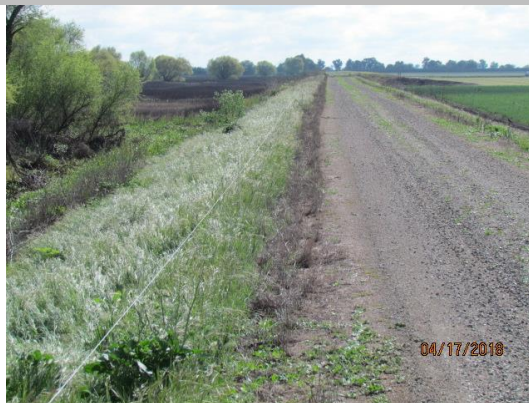
Photo 2 of 2 : SP\_2018\_NA0010\_124\_89\_20180420\_00182.jpg

LM Start	13.24	Rating **	M	Issue No.	89 (cont)	
LM End	15.66	Issue Type +	En	Location *	WS	
Category	Earthen Levee			GPS Latitude/Longitude		
				Start		End
Item	Encroachments			37.171680 °	37.157145 °	
				-120.654574 °	-120.617501 °	
DWR ID	DWR_NA0010_06_s_2018_89					
Comment Code						
FE : Fence						
Inspector Comment						
Electric fence installed on waterward shoulder.

Looking north at electric fence on waterward shoulder. (Spring 2018)

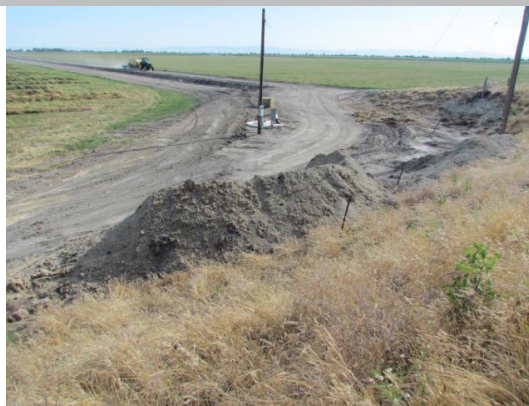
Photo 1 of 1 : SP\_2018\_NA0010\_124\_68\_20180307\_00018.jpg

LM Start	13.24	Rating **	M	Issue No.	68
LM End	13.24	Issue Type +	En	Location *	LS
Category	Earthen Levee			GPS Latitude/Longitude	
				Start	End
Item	Encroachments			37.171686 °	37.171686 °
				-120.654562 °	-120.654562 °
DWR ID	DWR_NA0010_06_f_2015_68				
Comment Code					
MA : Material					
Inspector Comment					
Landowner stockpiled dirt at landside toe.

Looking west at dirt stockpile at landward toe.

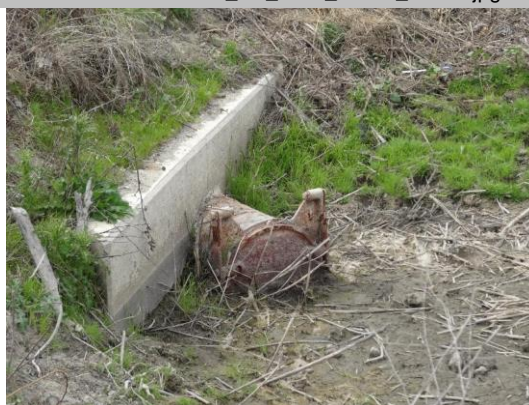
Photo 1 of 3 : UCIP\_SP\_2018\_39480\_66507.jpg

LM Start	15.68	Rating **	M	Issue No.	1252
LM End	15.68	Issue Type +	Ma	Location *	
Category	Supplemental			GPS Latitude/Longitude	
				Start	End
Item	DWR UCIP LMA Responsibility			37.156934 °	37.156934 °
				-120.617210 °	-120.617210 °
DWR ID					
Comment Code					
Inspector Comment					
FS_ID:39480 DS_ID:19884 EP_NO: N/A Repair Type: Non-Urgent Crossing Status: Found UCIP Comments: Need to contact owner. Sediment buildup on both the waterward and landward side. Recommend removing sediment buildup from both side. Also recommend clearing excess sediment inside crossing. FIELD_STRUCT_DESC: 24-inch corrugated metal gravity drainage pipe through the levee, 14 feet below the crown. Flap gate on the waterside (WS) end. [Additional Reference(s): DWR Levee Log, 2002. USACE San Joaquin O&M Manual 601.1, 1967, (HLM 15.76)]. FS Date: 4/17/2014

Flap gate buried halfway on waterward side.

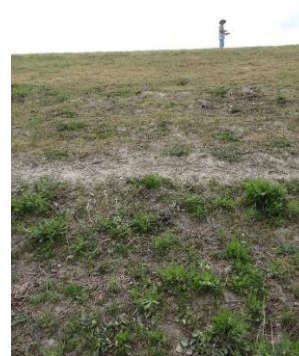
Photo 1 of 3 : UCIP\_SP\_2018\_36663\_66530.jpg

Comment Code					
Inspector Comment					
FS_ID:36663 DS_ID:19885 EP_NO: N/A Repair Type: Non-Urgent Crossing Status: Found UCIP Comments: Need to contact owner to determine status of crossing. Waterward side is buried and not accessible. Landward side headwall is blocked by dense vegetation. Recommend confirming status of flap gate on waterward side and removing dense vegetation form landward side. FIELD_STRUCT_DESC: 36-inch corrugated metal gravity drainage pipe through the levee, 16.6 feet below the crown. Flap gate on the waterside (WS) end. [Additional Reference(s): DWR Levee Log, 2002. USACE San Joaquin O&M Manual 601.1, 1967, (HLM 15.91)]. FS Date: 4/17/2014

View of waterward side, Photo 1 of 3.

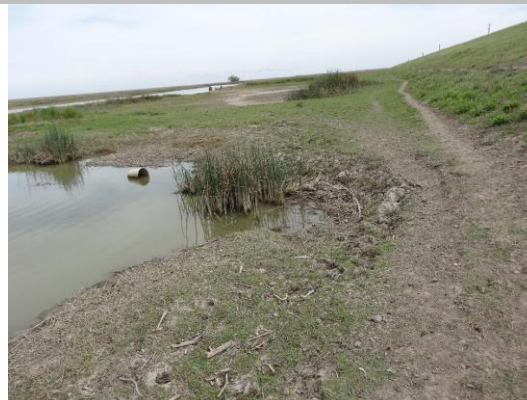
Photo 2 of 3 : UCIP\_SP\_2018\_36663\_66526.jpg

View of waterward side, photo 2 of 3.

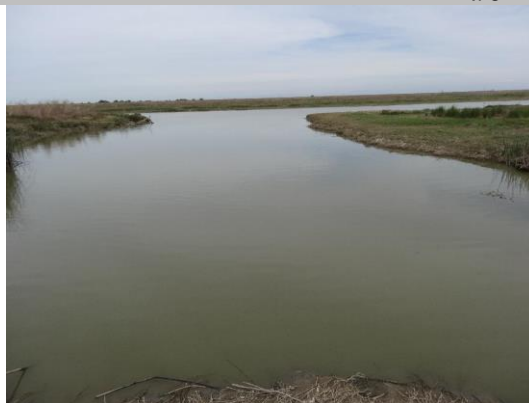
Photo 3 of 3 : UCIP\_SP\_2018\_36663\_66529.jpg

Item	DWR UCIP LMA Responsibility			37.155539 °		37.155539 °
				-120.615303 °		-120.615303 °
DWR ID						
Comment Code						
Inspector Comment						
FS_ID:36663 DS_ID:19885 EP_NO: N/A Repair Type: Non-Urgent Crossing Status: Found UCIP Comments: Need to contact owner to determine status of crossing. Waterward side is buried and not accessible. Landward side headwall is blocked by dense vegetation. Recommend confirming status of flap gate on waterward side and removing dense vegetation form landward side. FIELD_STRUCT_DESC: 36-inch corrugated metal gravity drainage pipe through the levee, 16.6 feet below the crown. Flap gate on the waterside (WS) end. [Additional Reference(s): DWR Levee Log, 2002. USACE San Joaquin O&M Manual 601.1, 1967, (HLM 15.91)]. FS Date: 4/17/2014

View of waterward side, photo 3 of 3.

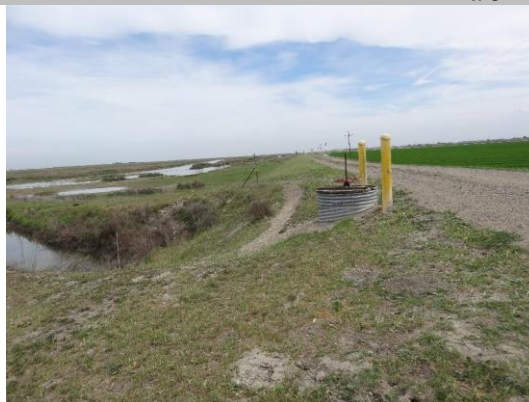
Photo 1 of 3 : UCIP\_SP\_2018\_36665\_66541.jpg

LM Start	16.40	Rating **	M	Issue No.	1254	
LM End	16.40	Issue Type +	En	Location *		
Category	Supplemental			GPS Latitude/Longitude		
				Start	End	
Item	DWR UCIP Field Study			37.149747 °	37.149747 °	
				-120.607702 °	-120.607702 °	
DWR ID						
Comment Code						
Inspector Comment						
FS_ID:36665 DS_ID:19559 EP_NO: N/A Repair Type: Non-Urgent Crossing Status: Found UCIP Comments: Need to contact owner to determine status of crossing. Unable to confirm pipe diameter. FIELD_STRUCT_DESC: 36-inch corrugated metal irrigation siphon pipe through the levee, 5.9 feet below the crown. Slide gate on the waterside (WS). Siphon extends under channel. [Additional Reference(s): USACE San Joaquin O&M Manual 601.1, 1967, (HLM 16.49)]. FS Date: 4/17/2014

View of waterward side.

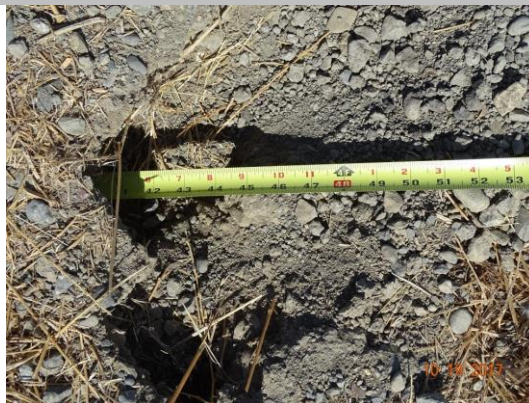
Photo 1 of 1 : SP\_2018\_NA0010\_124\_73\_20180307\_00024.jpg

LM Start	16.91	Rating **	U	Issue No.	73
LM End	16.91	Issue Type +	Ma	Location *	CR
Category	Earthen Levee			GPS Latitude/Longitude	
				Start	End
Item	Animal Control			37.143827 °	37.143827 °
				-120.602204 °	-120.602204 °
DWR ID	DWR_NA0010_06_f_2017_73				
Comment Code					
A3 : No rodents visible, but rodent burrows visible; need to backfill and compact or grout burrows.					
Inspector Comment					
Rodent hole on crown that travels approximately 4 feet to landside slope.

Looking at rodent hole in levee crown.

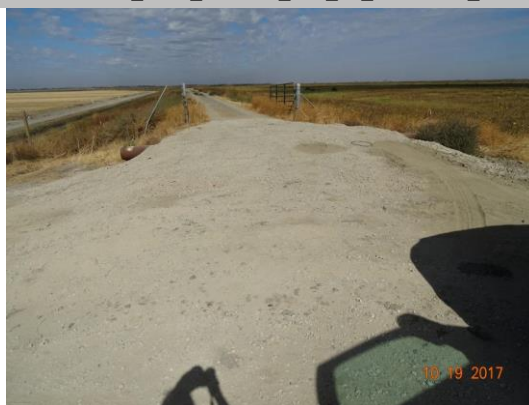
Photo 1 of 1 : SP\_2018\_NA0010\_124\_72\_20180307\_00023.jpg

LM Start	18.18	Rating **	U	Issue No.	72
LM End	18.18	Issue Type +	En	Location *	CR
Category	Earthen Levee			GPS Latitude/Longitude	
				Start	End
Item	Encroachments			37.127982 °	37.127982 °
				-120.590911 °	-120.590911 °
DWR ID	DWR_NA0010_06_f_2017_72				
Comment Code					
PI : Pipe					
Inspector Comment					
Non permitted pipe across the levee crown.

Looking northwest at the pipe across the levee crown.

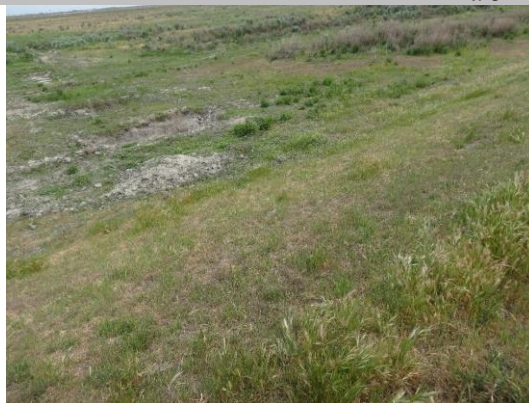
Photo 1 of 3 : UCIP\_SP\_2018\_49974\_66562.jpg

FS\_ID:49974  
DS\_ID:19888  
EP\_NO: 3040  
Repair Type: Urgent  
Crossing Status: Found  
UCIP Comments: 7/20/2016 Same as previous inspection. Dense vegetation prevents proper inspection along floodway. (DWR UCIP - omagana)4/17/2014 Need to contact owner. Leak on waterward toe approximately 15 feet from toe. Good candidate for video or pressure test. (DWR UCIP - omagana)  
FIELD\_STRUCT\_DESC: 48-inch corrugated metal irrigation siphon pipe through the levee, 8.8 feet below the crown. Slide gate in a pipe riser on the landside (LS) slope, not the waterside (WS) slope. Concrete headwall on the LS, not the WS. Siphon extends under the channel. 24-inch corrugated metal cleanout pipe at the center of the channel with a metal plate cover. (Plans for construction of two reinforced concrete siphons across the Eastside Bypass authorized under Permit No. 3040, 1959 - Newhall Land and Farming Company). [Additional Reference(s): DWR Levee Log, 2002].

View of WS. Channel section exposed near waterward toe.

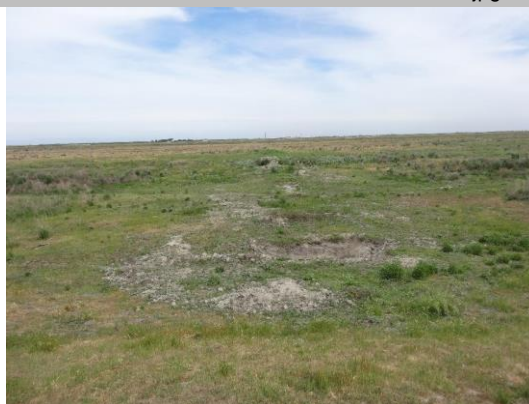
Photo 2 of 3 : UCIP\_SP\_2018\_49974\_66564.jpg

Overview of Eastside Bypass.

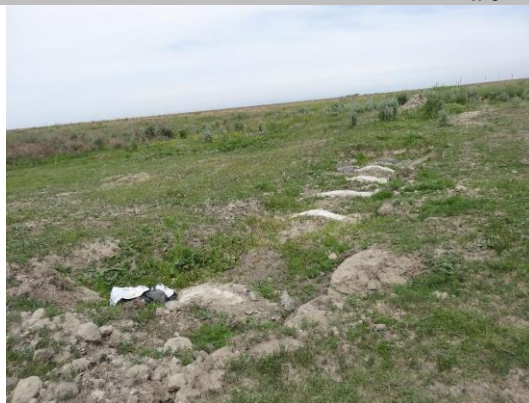
Photo 3 of 3 : UCIP\_SP\_2018\_49974\_66563.jpg

Item	DWR UCIP Field Study			37.119268 °		37.119268 °
				-120.587208 °		-120.587208 °
DWR ID						
Comment Code						
Inspector Comment						
FS_ID:49974 DS_ID:19888 EP_NO: 3040 Repair Type: Urgent Crossing Status: Found UCIP Comments: 7/20/2016 Same as previous inspection. Dense vegetation prevents proper inspection along floodway. (DWR UCIP - omagana)4/17/2014 Need to contact owner. Leak on waterward toe approximately 15 feet from toe. Good candidate for video or pressure test. (DWR UCIP - omagana) FIELD_STRUCT_DESC: 48-inch corrugated metal irrigation siphon pipe through the levee, 8.8 feet below the crown. Slide gate in a pipe riser on the landside (LS) slope, not the waterside (WS) slope. Concrete headwall on the LS, not the WS. Siphon extends under the channel. 24-inch corrugated metal cleanout pipe at the center of the channel with a metal plate cover. (Plans for construction of two reinforced concrete siphons across the Eastside Bypass authorized under Permit No. 3040, 1959 - Newhall Land and Farming Company). [Additional Reference(s): DWR Levee Log, 2002]. FS Date: 7/20/2016

Channel sections have been excavated across Eastside Bypass.

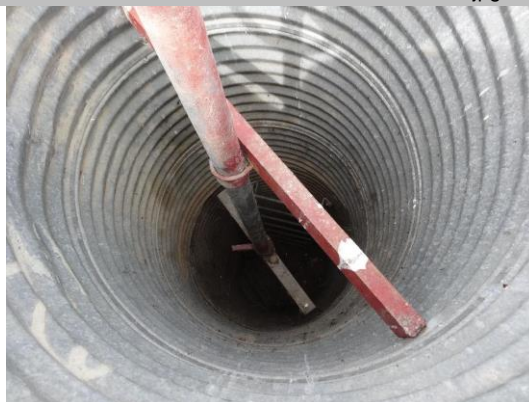
Photo 2 of 3 : UCIP\_SP\_2018\_36687\_66582.jpg

Inside view of CMP riser located on waterward slope.

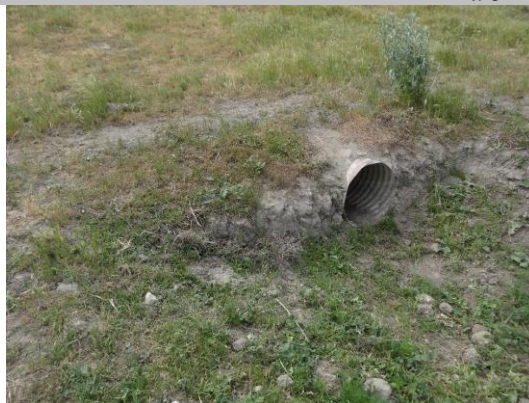
Photo 3 of 3 : UCIP\_SP\_2018\_36687\_66581.jpg

Item	DWR UCIP LMA Responsibility			37.118178 °	37.118178 °	
				-120.586783 °	-120.586783 °	
DWR ID						
Comment Code						
Inspector Comment						
FS_ID:36687 DS_ID:19889 EP_NO: N/A Repair Type: Non-Urgent Crossing Status: Found UCIP Comments: Dense vegetation limits the inspector's visibility to identify signs of pipe failure (leaks) along the landward slope. Recommend removing vegetation along pipe alignment to conduct proper inspection of structure. FIELD_STRUCT_DESC: 24-inch corrugated metal gravity drainage pipe through the levee, 10.2 feet below the crown. Slide gate in a pipe riser on the waterside (WS) slope. [Additional Reference(s): DWR Levee Log, 2002. USACE San Joaquin O&M Manual 601.1, 1967, (HLM 18.97)]. FS Date: 4/17/2014

Pipe daylight on waterward side.

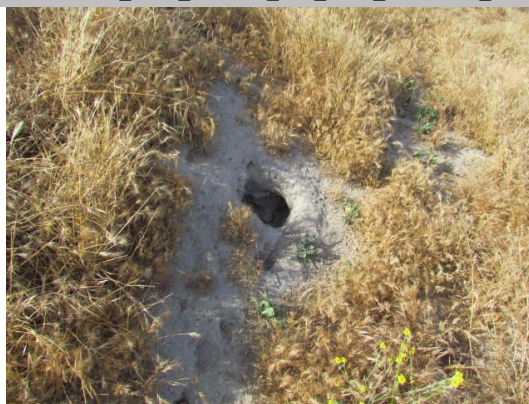
Photo 1 of 5 : SP\_2018\_NA0010\_124\_1211\_20180307\_00041.jpg

LM Start	19.14	Rating **	U	Issue No.	1211
LM End	19.14	Issue Type +	Ma	Location *	WS
Category	Earthen Levee			GPS Latitude/Longitude	
				Start	End
Item	Animal Control			37.114793 °	37.114793 °
				-120.587582 °	-120.587582 °
DWR ID	DWR_NA0010_06_s_2015_1211				
Comment Code					
A1 : Exterminate rodents and backfill and compact or grout burrows.					
Inspector Comment					
Several large rodent holes with more than 2 cubic feet of material were noted on the waterside slope.

Looking at rodent hole on waterward slope. Spring 2016

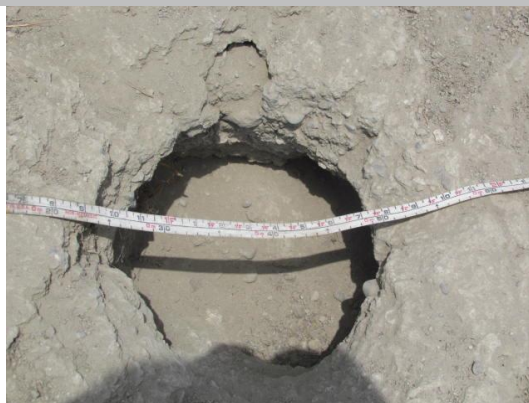
Photo 3 of 5 : SP\_2018\_NA0010\_124\_1211\_20180307\_00043.jpg

Looking at close-up view of large rodent hole on waterward slope. (Spring 2015)

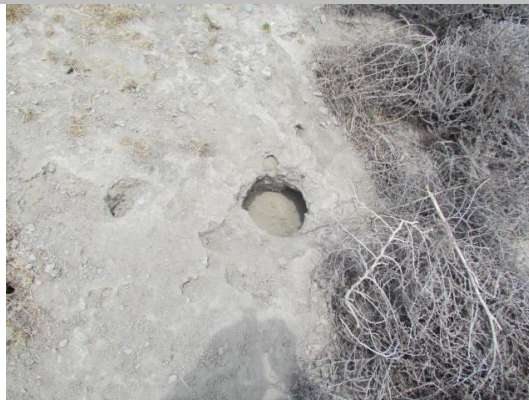
Photo 4 of 5 : SP\_2018\_NA0010\_124\_1211\_20180307\_00044.jpg

Looking at large rodent hole on waterward slope. Spring 2015

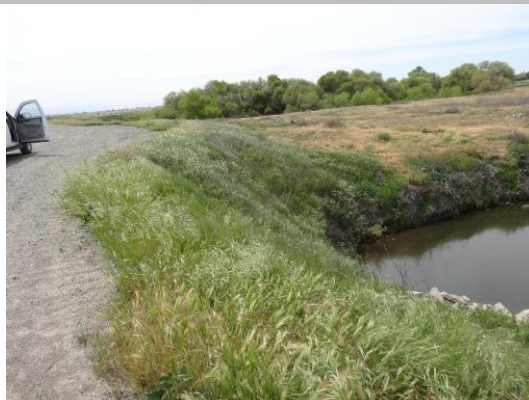
Photo 3 of 3 : UCIP\_SP\_2018\_36688\_66586.jpg

View of landward slope.

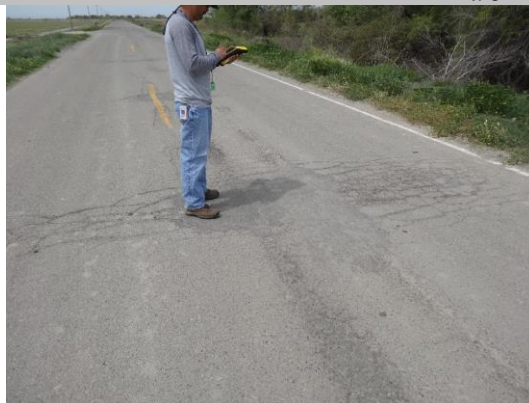
Photo 1 of 3 : UCIP\_SP\_2018\_36689\_66591.jpg

Comment Code					
Inspector Comment					
FS_ID:36689					
DS_ID:19891					
EP_NO: N/A					
Repair Type: Non-Urgent					
Crossing Status: Found					
UCIP Comments: Dense vegetation limits the inspector's visibility to identify signs of pipe failure (leaks) along the slopes. Recommend removing vegetation along pipe alignment to conduct proper inspection of structure.					
FIELD_STRUCT_DESC: 30-inch by 30-inch reinforced concrete box gravity drainage culvert through the levee, 14 feet below the crown. Flap gate on the waterside (WS) end. [Additional Reference(s): DWR Levee Log, 2002. USACE San Joaquin O&M Manual 601.1, 1967, (HLM 19.85)].					
FS Date: 4/17/2014

Overview of levee crown looking downstream.

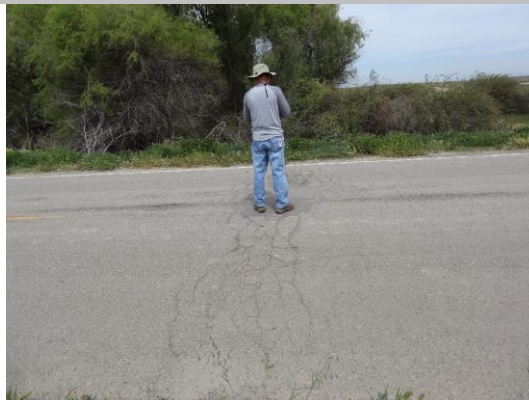
Photo 2 of 3 : UCIP\_SP\_2018\_36689\_66592.jpg

View of levee crown at crossing.

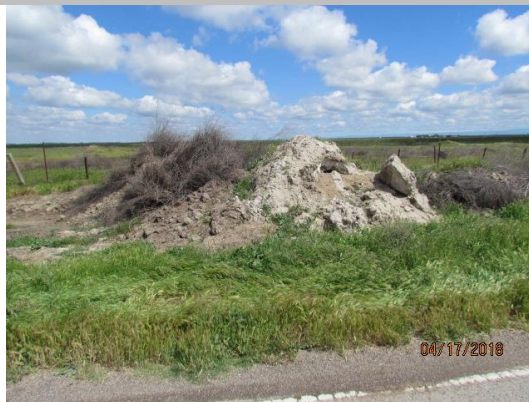
Photo 1 of 1 : SP\_2018\_NA0010\_124\_71\_20180420\_00184.jpg

LM Start	20.05	Rating **	M	Issue No.	71
LM End	20.05	Issue Type +	Ma	Location *	WS
Category	Earthen Levee			GPS Latitude/Longitude	
				Start	End
Item	Encroachments			37.113256 °	37.113256 °
				-120.577092 °	-120.577092 °
DWR ID	DWR_NA0010_06_s_2018_71				
Comment Code					
MA : Material					
Inspector Comment					
Material stock pile on waterward shoulder.

Looking east at material stockpile on waterward shoulder. (Spring 2018)

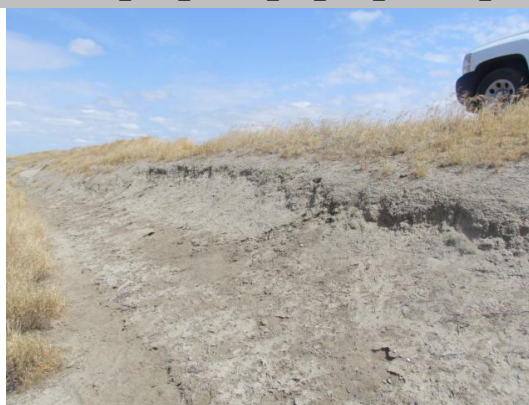
Photo 2 of 2 : SP\_2018\_NA0010\_124\_1209\_20180307\_00040.jpg

LM Start	20.79	Rating **	M	Issue No.	1209
LM End	20.88	Issue Type +	Ma	Location *	LS
Category	Earthen Levee			GPS Latitude/Longitude	
				Start	End
Item	Erosion / Bank Caving			37.113107 °	37.112176 °
				-120.563782 °	-120.562516 °
DWR ID	DWR_NA0010_06_s_2015_1209				
Comment Code					
E1 : Note and monitor erosion site.					
Inspector Comment					
Erosion on landside slope greater than 3 inches. Erosion caused by livestock.

Looking northeast at livestock erosion on landward slope.

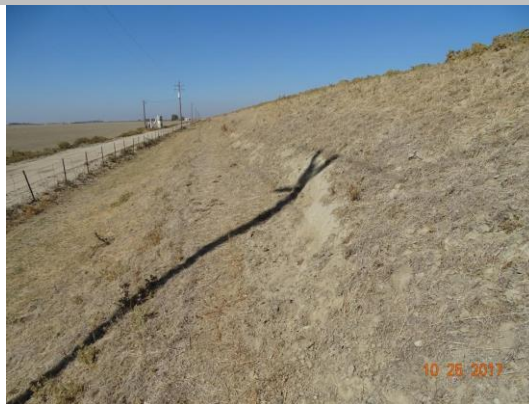
Photo 1 of 1 : SP\_2018\_NA0010\_124\_86\_20180307\_00035.jpg

LM Start	22.41	Rating **	M	Issue No.	86
LM End	22.46	Issue Type +	Ma	Location *	LS
Category	Earthen Levee			GPS Latitude/Longitude	
				Start	End
Item	Slope Stability			37.094969 °	37.094479 °
				-120.544964 °	-120.544435 °
DWR ID	DWR_NA0010_06_f_2017_86				
Comment Code					
S2 : Repair the levee slope damaged by foot traffic and prevent access where possible.					
Inspector Comment					
Erosion greater than 3 inches on landside slope caused by livestock.

Looking northwest at the landside slope.

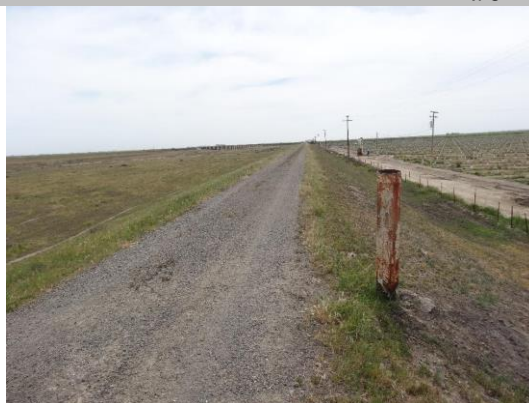
Photo 1 of 3 : UCIP\_SP\_2018\_34010\_61871.jpg

Comment Code						
Inspector Comment						
FS_ID:34010 DS_ID:19879 EP_NO: 13638 Repair Type: Non-Urgent Crossing Status: Found UCIP Comments: Need to contact owner to determine status. Crossing has been modified. FIELD_STRUCT_DESC: 16-inch coated steel irrigation discharge pipe through the levee, 3.5 feet below the crown. Cutoff wall around the pipe at the center of the levee. Pump on the waterside (WS). Siphon breaker on the landside (LS) shoulder. Intake trench on the WS. (Plans to install a pump with a 16-inch pipeline over the levee authorized under Permit No. 13638, 1983 - Hamonds Ranch). [Additional Reference(s): DWR Levee Log, 2002]. FS Date: 4/17/2014

Overview of levee crown at crossing.

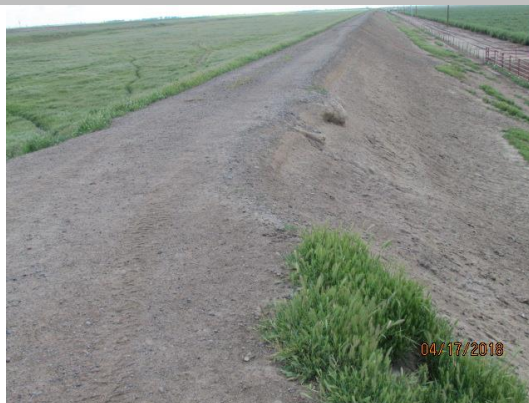
Photo 1 of 4 : SP\_2018\_NA0010\_124\_5\_20180420\_00185.jpg

LM Start	24.58	Rating **	M	Issue No.	5
LM End	24.93	Issue Type +	Ma	Location *	LS
Category	Earthen Levee			GPS Latitude/Longitude	
				Start	End
Item	Slope Stability			37.071198 °	°
				-120.519220 °	°
DWR ID	DWR_NA0010_06_s_2012_5				
Comment Code					
S2 : Repair the levee slope damaged by foot traffic and prevent access where possible.					
Inspector Comment					
Landside erosion caused by livestock extends into landward shoulder.

Looking north at livestock erosion into landward shoulder. (Spring 2018)

LM Start	24.58	Rating **	M	Issue No.	5 (cont)	
LM End	24.93	Issue Type +	Ma	Location *	LS	
Category	Earthen Levee			GPS Latitude/Longitude		
				Start		End
Item	Slope Stability			37.071198 °		°
				-120.519220 °		°
DWR ID	DWR_NA0010_06_s_2012_5					
Comment Code						
S2 : Repair the levee slope damaged by foot traffic and prevent access where possible.						
Inspector Comment						
Landside erosion caused by livestock extends into landward shoulder.

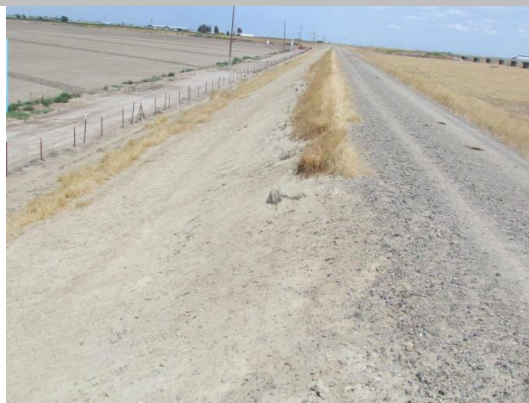
Photo 2 of 4 : SP\_2018\_NA0010\_124\_5\_20180307\_00007.jpg

Looking north at livestock erosion on landward slope. (Spring 2015)

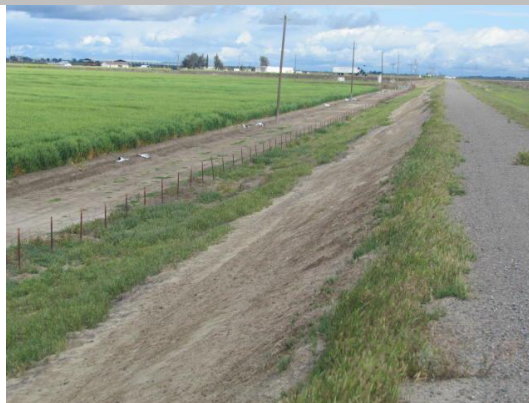
Photo 4 of 4 : SP\_2018\_NA0010\_124\_5\_20180307\_00009.jpg

Looking north at livestock erosion on landside slope. (Fall 2014)

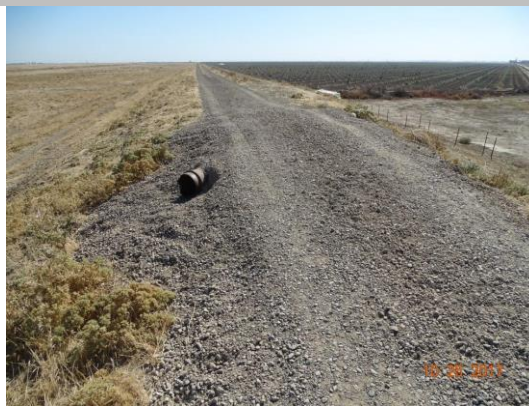
Photo 1 of 1 : SP\_2018\_NA0010\_124\_83\_20180307\_00034.jpg

LM Start	24.98	Rating **	M	Issue No.	83
LM End	24.98	Issue Type +	En	Location *	CR
Category	Earthen Levee			GPS Latitude/Longitude	
				Start	End
Item	Encroachments			37.066893 °	37.066893 °
				-120.514623 °	-120.514623 °
DWR ID	DWR_NA0010_06_f_2017_83				
Comment Code					
PI : Pipe					
Inspector Comment					
Landowner has a temporary pipe across the crown.

Looking southeast at the pipe on the levee crown.

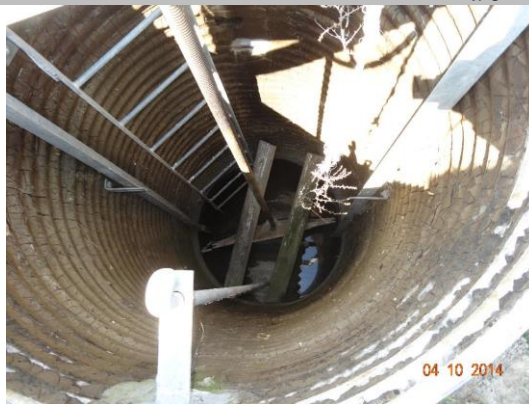
Photo 2 of 3 : UCIP\_SP\_2018\_39886\_66603.jpg

Inside view of CMP riser located on waterward slope.

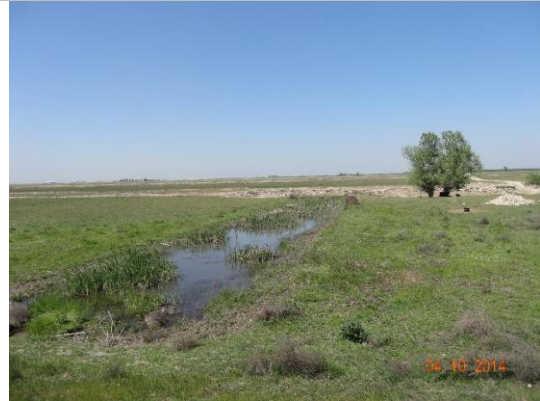
Photo 3 of 3 : UCIP\_SP\_2018\_39886\_66599.jpg

View of waterward side.

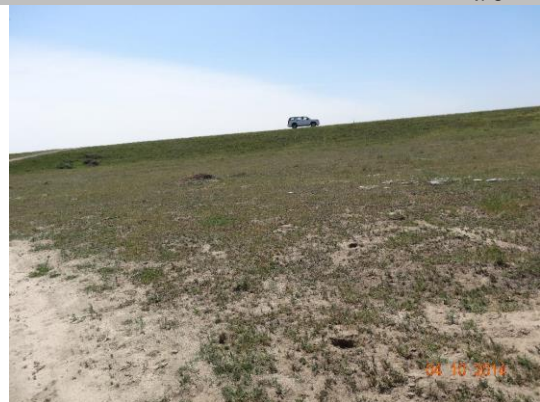
Photo 1 of 3 : UCIP\_SP\_2018\_36693\_66607.jpg

Comment Code						
Inspector Comment						
FS_ID:36693						
DS_ID:19882						
EP_NO: N/A						
Repair Type: Non-Urgent						
Crossing Status: Found						
UCIP Comments: Altered crossing--steel pipe section on landward side						
and concrete pipe section on waterward side. Joints on waterward side						
seperated. Need to contact owner to determine status.						
FIELD_STRUCT_DESC: [Rodunder Siphon Structure] 48-inch						
reinforced concrete irrigation siphon pipe through the levee, 14.5 feet						
below the crown. Concrete U-shaped headwall on the outlet structure						
on the landside (LS) end. Slide gate mounted on the headwall.						
[Additional Reference(s): DWR Levee Log, 2002. USACE San Joaquin						
O&M Manual 601.1, 1967, (HLM 30.27)].						
FS Date: 4/10/2014

Overview of waterward side.

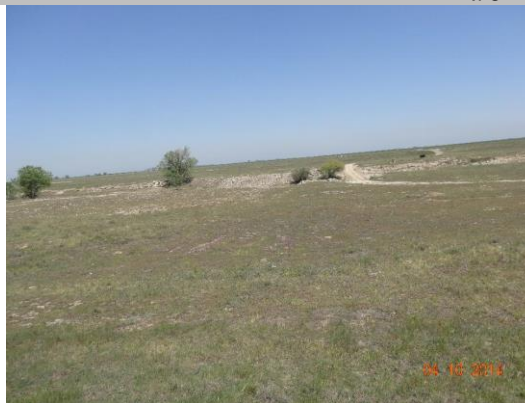
Photo 2 of 3 : UCIP\_SP\_2018\_36693\_66604.jpg

Overview of Eastside Bypass at crossing.

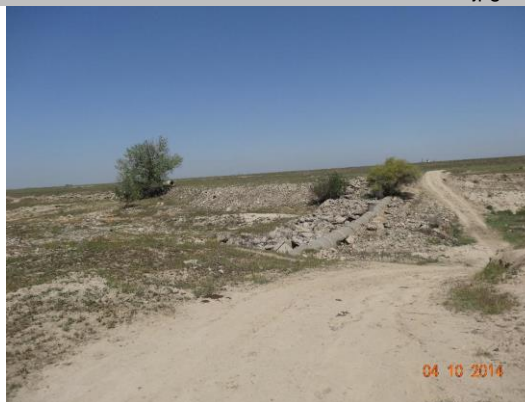
Photo 3 of 3 : UCIP\_SP\_2018\_36693\_66609.jpg

Concrete pipe through Eastside Bypass exposed.

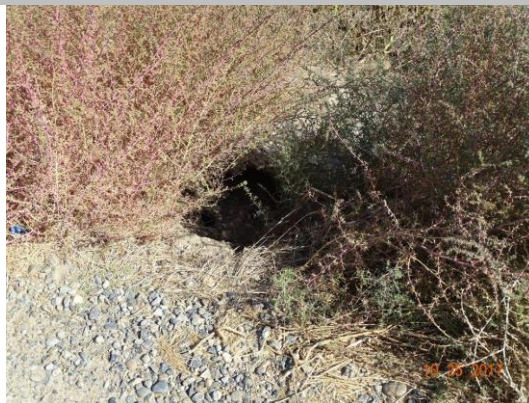
Photo 1 of 1 : SP\_2018\_NA0010\_124\_82\_20180307\_00033.jpg

Looking east at the waterside slope.

LM Start	31.14	Rating **	U	Issue No.	82
LM End	31.14	Issue Type +	Ma	Location *	WS
Category	Earthen Levee			GPS Latitude/Longitude	
				Start	End
Item	Animal Control			37.017445 °	37.017445 °
				-120.434713 °	-120.434713 °
DWR ID	DWR_NA0010_06_f_2017_82				
Comment Code					
A3 : No rodents visible, but rodent burrows visible; need to backfill and compact or grout burrows.					
Inspector Comment

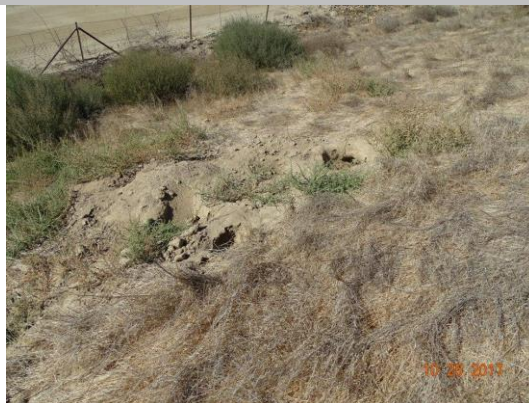
Photo 1 of 1 : SP\_2018\_NA0010\_124\_81\_20180307\_00032.jpg

Looking west at the landside slope.

LM Start	32.00	Rating **	U	Issue No.	81
LM End	32.00	Issue Type +	Ma	Location *	LS
Category	Earthen Levee			GPS Latitude/Longitude	
				Start	End
Item	Animal Control			37.007007 °	37.007007 °
				-120.426179 °	-120.426179 °
DWR ID	DWR_NA0010_06_f_2017_81				
Comment Code					
A3 : No rodents visible, but rodent burrows visible; need to backfill and compact or grout burrows.					
Inspector Comment

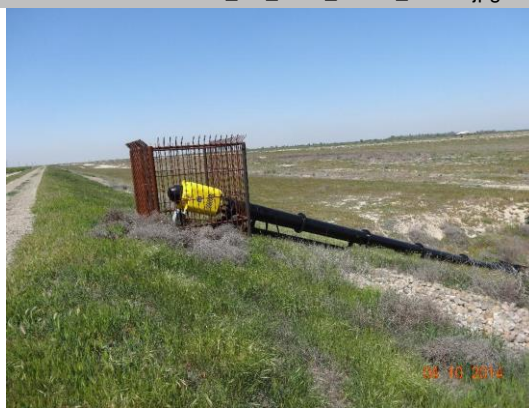
Photo 1 of 3 : UCIP\_SP\_2018\_46183\_61898.jpg

Comment Code					
Inspector Comment					
FS_ID:46183 DS_ID:19883 EP_NO: 6416A Repair Type: Non-Urgent Crossing Status: Found UCIP Comments: Crossing updated--need to contact owner to determine permit issued by CVFPB for authorized changes. FIELD_STRUCT_DESC: 20-inch (not 18 inch as mentioned in the DS study) coated steel drainage discharge pipe through the levee, 3.9 feet below the crown. Electrical conduit through the levee. Cutoff wall around pipe at centerline of levee. Capped with a welded plate on the landside (LS) end. Siphon breaker on the apex of the pipe on the LS shoulder. Slant pump on the waterside (WS) slope. (To revise plans for a slant pump and an 18-inch steel pipe through the levee authorized under Permit No. 6416-A, 1975 - Triangle T. Ranch, Inc.). [Additional Reference(s): DWR Levee Log, 2002]. FS Date: 4/10/2014

View of waterward side--pipe and pump fenced off on waterward slope.

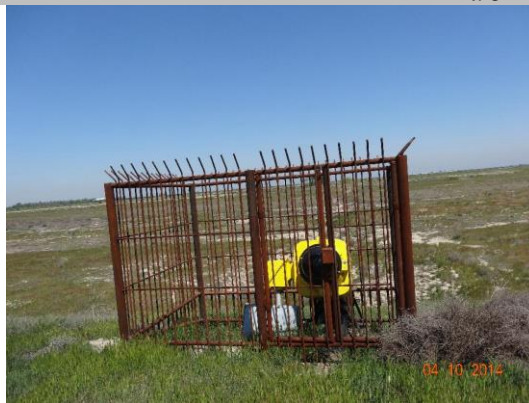
Photo 2 of 3 : UCIP\_SP\_2018\_46183\_61902.jpg

Electrical conduit visible on waterward slope.

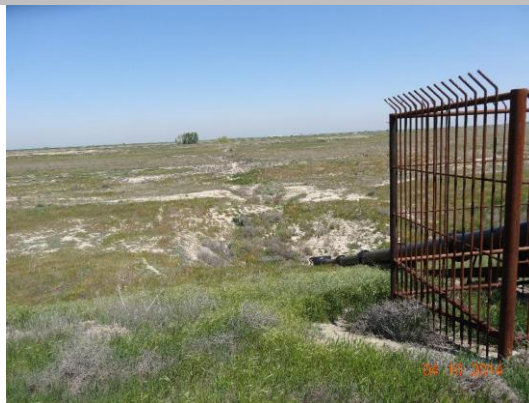
Photo 3 of 3 : UCIP\_SP\_2018\_46183\_61903.jpg

View of Eastside Bypass.
