**Flood Control Project Maintenance  
Levee Inspections**  
**LMA District Cover Sheet**  
**Spring 2018 Levee Inspection Results**

**Lower San Joaquin Levee District**

**Spring 2018 Levee Inspection Results**

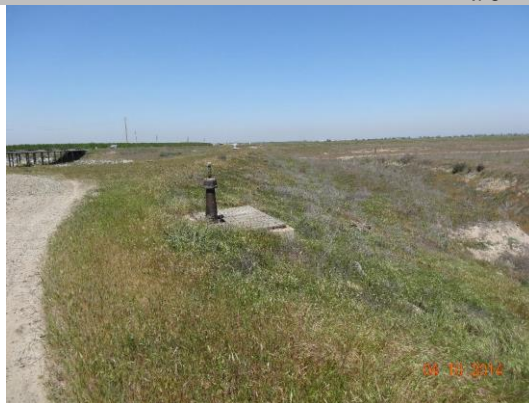
Photo 1 of 3 : UCIP\_SP\_2018\_39481\_66628.jpg

Comment Code						
Inspector Comment						
FS_ID:39481						
DS_ID:19813						
EP_NO: N/A						
Repair Type: Non-Urgent						
Crossing Status: Found						
UCIP Comments: Dense vegetation limits the inspector's visibility to identify signs of pipe failure (leaks) along the slope. Recommend removing vegetation along pipe alignment to conduct proper inspection of structure and appurtenances. High vegetation along crossing alignment--recommend removing vegetation along pipe crossing.						
FIELD_STRUCT_DESC: 48-inch by 72-inch reinforced concrete box gravity irrigation culvert through the levee, 15.1 feet below the crown. Slide gate in a concrete riser in the waterside (WS) slope. Concrete U-shaped headwall on each end. Landside (LS) channel cobble revetted for 8 feet. [Additional Reference(s): DWR Levee Log, 2002. USACE San Joaquin O&M Manual 601.1, 1967, (HLM 35.33)].						
FS Date: 4/10/2014

View of waterward side--slide gate inside concrete box.

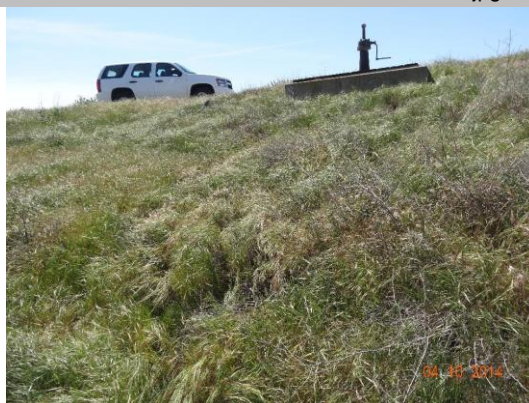
Photo 2 of 3 : UCIP\_SP\_2018\_39481\_66632.jpg

View of waterward slope covered by dense vegetation.

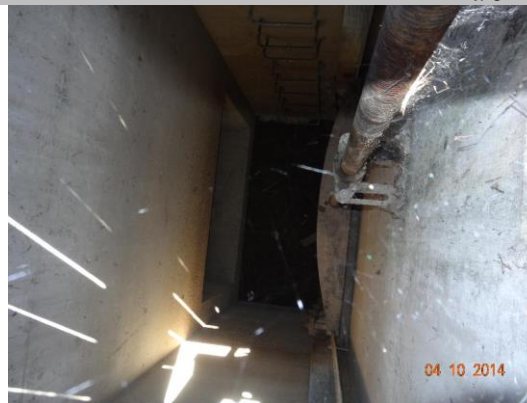
Photo 3 of 3 : UCIP\_SP\_2018\_39481\_66629.jpg

Item	DWR UCIP Field Study			36.974509 °	36.974509 °	
				-120.382056 °	-120.382056 °	
DWR ID						
Comment Code						
Inspector Comment						
FS_ID:39481 DS_ID:19813 EP_NO: N/A Repair Type: Non-Urgent Crossing Status: Found UCIP Comments: Dense vegetation limits the inspector's visibility to identify signs of pipe failure (leaks) along the slope. Recommend removing vegetation along pipe alignment to conduct proper inspection of structure and appurtenances. High vegetation along crossing alignment--recommend removing vegetation along pipe crossing. FIELD_STRUCT_DESC: 48-inch by 72-inch reinforced concrete box gravity irrigation culvert through the levee, 15.1 feet below the crown. Slide gate in a concrete riser in the waterside (WS) slope. Concrete U-shaped headwall on each end. Landside (LS) channel cobble revetted for 8 feet. [Additional Reference(s): DWR Levee Log, 2002. USACE San Joaquin O&M Manual 601.1, 1967, (HLM 35.33)]. FS Date: 4/10/2014

Inside view of concrete box located on waterward slope.

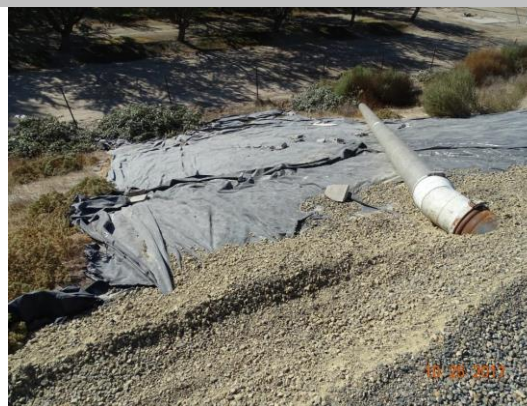
Photo 1 of 1 : SP\_2018\_NA0010\_124\_77\_20180307\_00029.jpg

LM Start	35.85	Rating **	M	Issue No.	77
LM End	35.85	Issue Type +	Ma	Location *	LS
Category	Earthen Levee			GPS Latitude/Longitude	
				Start	End
Item	Erosion / Bank Caving			36.974397 °	36.974397 °
				-120.374415 °	-120.374415 °
DWR ID	DWR_NA0010_06_f_2017_77				
Comment Code					
E2 : Schedule repair of erosion site prior to the next inspection.					
Inspector Comment					
Landowner installed a raincoat on landside levee at location of temporary pipe. Need to assess landside slope to determine/repair any possible damage.

Looking southwest at the landside slope.

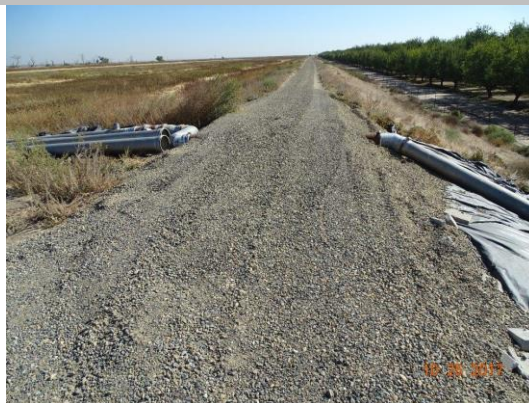
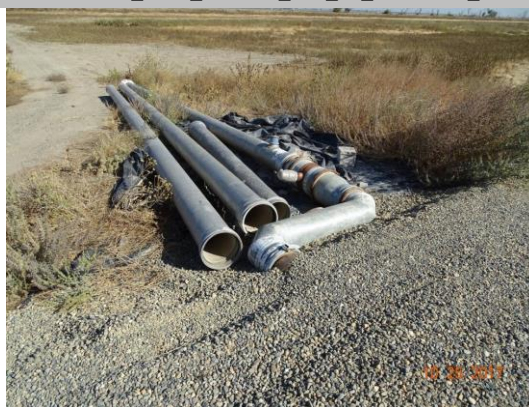
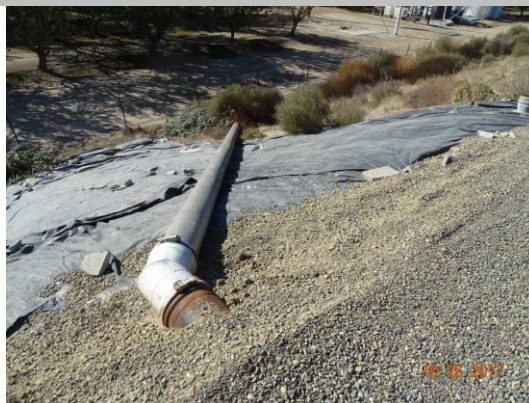
LM Start	<b>35.85</b>	Rating **	U	Issue No.	<b>75 (cont)</b>
LM End	<b>35.85</b>	Issue Type +	En	Location *	CR

Looking east at the levee crown pipe crossing.

Looking northeast at the waterside slope.

Looking southwest at the landside slope.

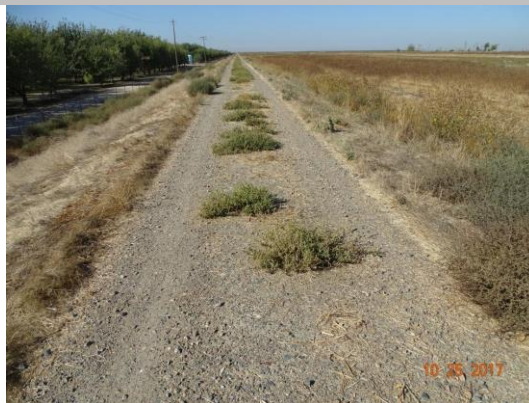
Photo 1 of 1 : SP\_2018\_NA0010\_124\_74\_20180307\_00025.jpg

LM Start	36.28	Rating **	A/W	Issue No.	74
LM End	36.39	Issue Type +	Ma	Location *	CR
Category	Earthen Levee			GPS Latitude/Longitude	
				Start	End
Item	Vegetation			36.974411 °	36.974422 °
				-120.366674 °	-120.364632 °
DWR ID	DWR_NA0010_06_f_2017_74				
Comment Code					
V1 : Control annual grass and weeds on the levee slopes and easements.					
Inspector Comment

Looking west at the levee crown.

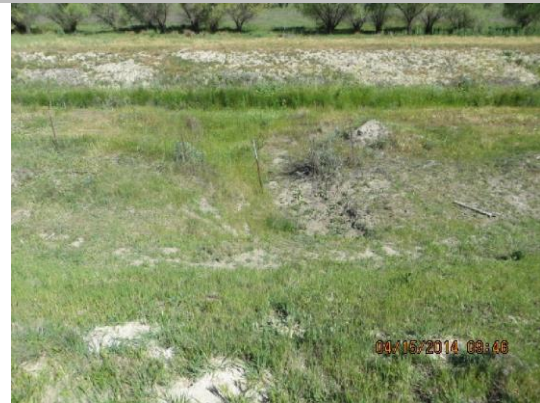
Photo 3 of 3 : UCIP\_SP\_2018\_49966\_60953.jpg

Comment Code						
Inspector Comment						
FS_ID:49966 DS_ID:19892 EP_NO: N/A Repair Type: Non-Urgent Crossing Status: Found UCIP Comments: 07/20/2016 Inlet blocked off by wooden board. Dense vegetation limits the inspector's visibility to identify signs of pipe failure (leaks) along WS and LS. Crossing downgraded from Urgent to Non-Urgent. (DWR UCIP - omagana)04/15/2014 Flapgate partially blocked by soil buildup at WS toe. (DWR UCIP - omagana) FIELD_STRUCT_DESC: 24-inch corrugated metal gravity drainage pipe through the levee, 10.8 feet below the crown. Flap gate on the waterside (WS) end. Concrete headwall on the landside (LS) end. Concrete U-shaped headwall on the WS end. [Additional Reference(s): DWR Levee Log, 2002. USACE San Joaquin O&M Manual 601.1, 1967, (HLM 0.07)]. FS Date: 7/20/2016

Pipe and headwall at LS toe.

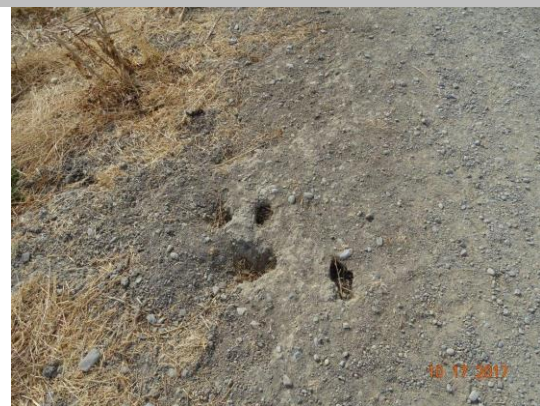
Photo 1 of 2 : SP\_2018\_NA0010\_125\_29\_20180307\_00008.jpg

LM Start	0.24	Rating **	M	Issue No.	29
LM End	0.50	Issue Type +	Ma	Location *	LS
Category	Earthen Levee			GPS Latitude/Longitude	
				Start	End
Item	Animal Control			37.256936 °	37.258722 °
				-120.768472 °	-120.764867 °
DWR ID	DWR_NA0010_07_s_2012_29				
Comment Code					
A3 : No rodents visible, but rodent burrows visible; need to backfill and compact or grout burrows.					
Inspector Comment					
Several rodent holes noted on landside and waterside slope and shoulder.

Looking north at landside slope.

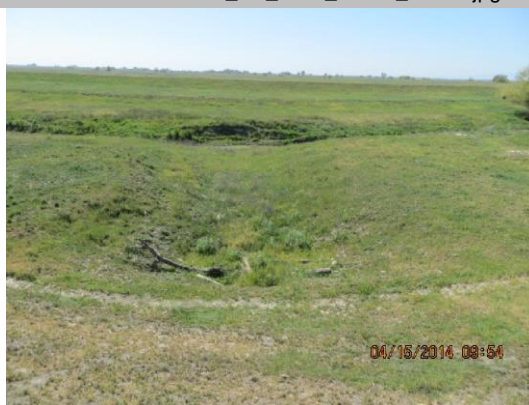
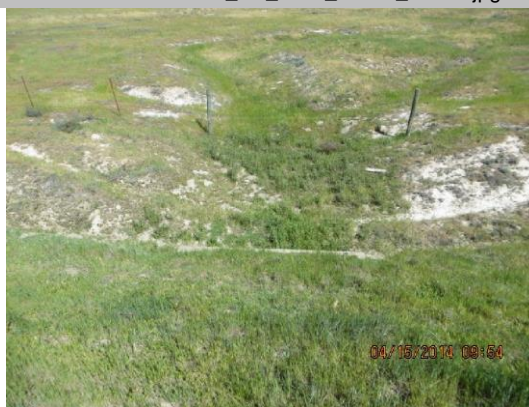
LM Start	0.33	Rating **	A/W	Issue No.	31
LM End	0.33	Issue Type +	Ma	Location *	
Category	Supplemental			GPS Latitude/Longitude	
				Start	End
Item	DWR UCIP LMA Responsibility			37.257691 °	37.257691 °
				-120.767203 °	-120.767203 °
DWR ID					
Comment Code					
Inspector Comment					
FS_ID:33712 DS_ID:19893 EP_NO: N/A Repair Type: No Action Needed Crossing Status: Found UCIP Comments: FIELD_STRUCT_DESC: 24-inch corrugated metal gravity drainage pipe through the levee, 11.1 feet below the crown. Flap gate on the waterside (WS) end. Concrete headwall on the landside (LS) end. Concrete U-shaped headwall on the WS end. [Additional Reference(s): DWR Levee Log, 2002. USACE San Joaquin O&M Manual 601.1, 1967, (HLM 0.33)]. FS Date: 4/15/2014

Pipe and headwall on WS toe.

Pipe, headwall, and flapgate on WS toe.

Pipe and headwall on LS toe.

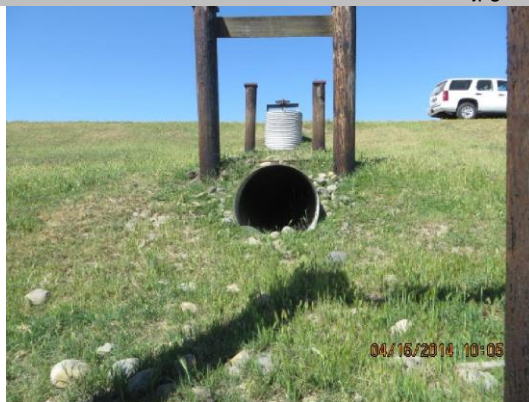
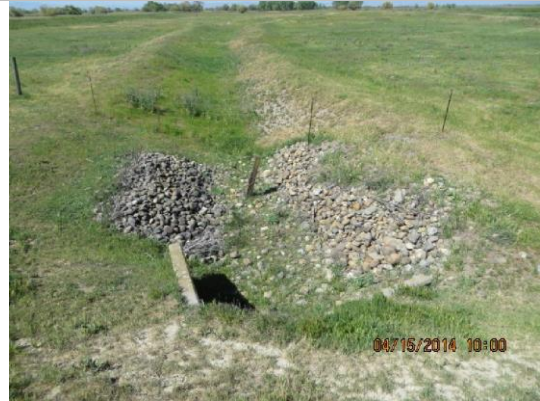
Comment Code					
Inspector Comment					
FS_ID:33713 DS_ID:19894 EP_NO: N/A Repair Type: Non-Urgent Crossing Status: Found UCIP Comments: Slide gate not operable, but left in closed position. Need to reinstall covers over slide gate standpipe. FIELD_STRUCT_DESC: 36-inch corrugated metal gravity drainage pipe through the levee, 9.7 feet below the crown. Slide gate in a 48-inch corrugated metal pipe (CMP) riser on the landside (LS) slope. Concrete U-shaped headwall on the LS end. Inlet channel cobble revetted. Dilapidated wooden pier on the waterside (WS). WS slope and outlet ditch cobble revetted. [Additional Reference(s): DWR Levee Log, 2002. USACE San Joaquin O&M Manual 601.1, 1967, (HLM 0.49)]. FS Date: 4/15/2014

Slide gate in CMP riser on WS slope.

Outlet on WS slope.

Pipe and headwall on LS toe.

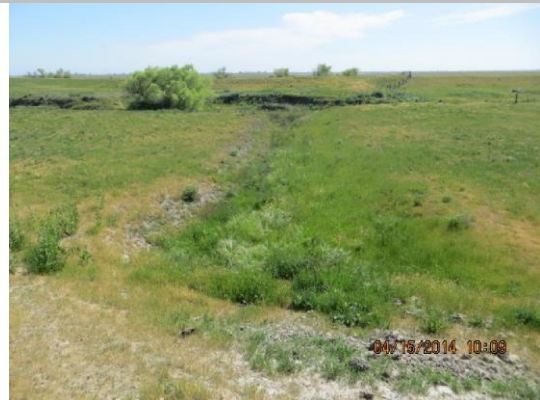
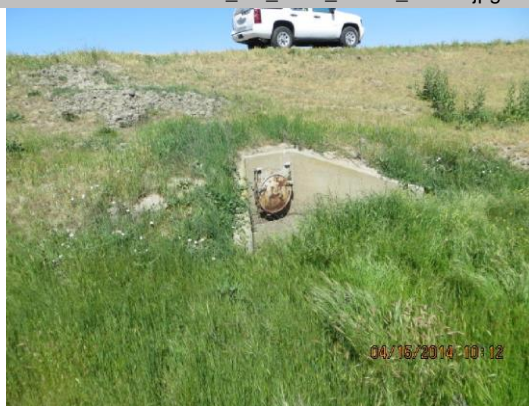
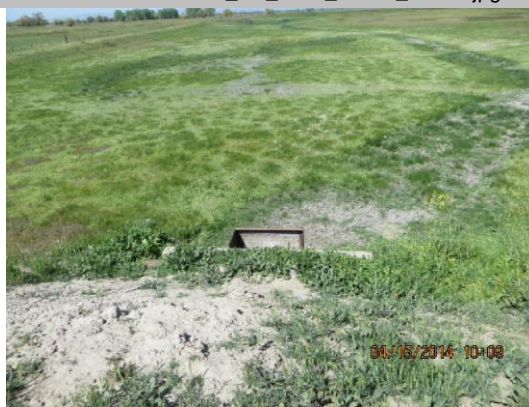
LM Start	0.53	Rating **	A/W	Issue No.	33
LM End	0.53	Issue Type +	Ma	Location *	
Category	Supplemental			GPS Latitude/Longitude	
				Start	End
Item	DWR UCIP LMA Responsibility			37.259163 °	37.259163 °
				-120.764860 °	-120.764860 °
DWR ID					
Comment Code					
Inspector Comment					
FS_ID:33723 DS_ID:19895 EP_NO: N/A Repair Type: No Action Needed Crossing Status: Found UCIP Comments: FIELD_STRUCT_DESC: 24-inch corrugated metal gravity drainage pipe through the levee, 9 feet below the crown. Flap gate on the waterside (WS) end. Concrete headwall with a wooden weir at the inlet on the landside (LS) toe. Concrete U-shaped headwall on the WS toe. [Additional Reference(s): DWR Levee Log, 2002. USACE San Joaquin O&M Manual 601.1, 1967, (HLM 0.53)]. FS Date: 4/15/2014

Headwall and flapgate on WS toe.

Flapgate on concrete headwall at WS toe.

Headwall, pipe, and wier on LS toe.

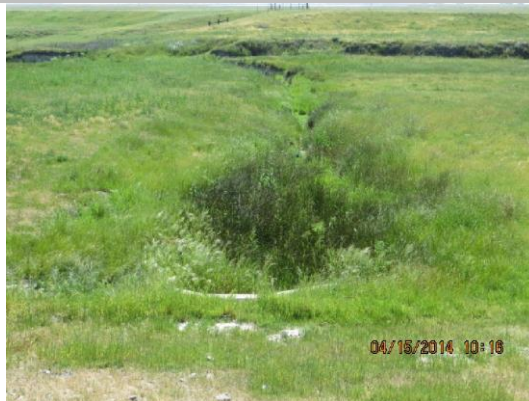
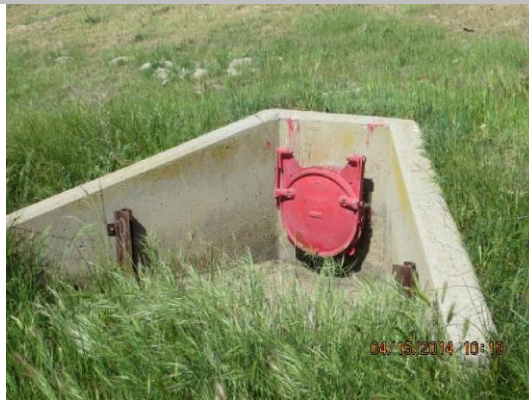
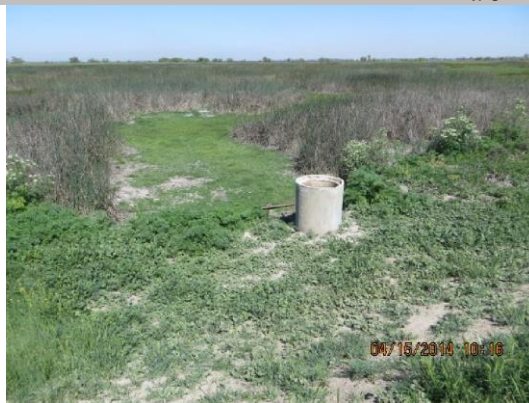
Comment Code					
Inspector Comment					
FS_ID:39507 DS_ID:19896 EP_NO: N/A Repair Type: Non-Urgent Crossing Status: Found UCIP Comments: Need to contact owner. Heavy sediment buildup at inlet due to animal activity should be cleared. FIELD_STRUCT_DESC: 24-inch corrugated metal gravity drainage pipe through the levee, 9.8 feet below the crown. Flap gate on the waterside (WS) end. Wooden weir on concrete headwall at the landside (LS) toe. 36-inch concrete riser at the LS toe. Concrete U-shaped headwall on the WS end. Concrete standpipe on the LS. [Additional Reference(s): DWR Levee Log, 2002. USACE San Joaquin O&M Manual 601.1, 1967, (HLM 0.85)]. FS Date: 4/15/2014

Headwall and flapgate on WS toe.

Concrete riser, concrete headwall, weir, and pipe at LS toe.

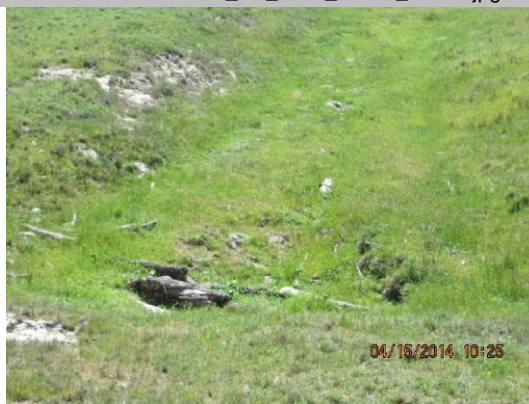
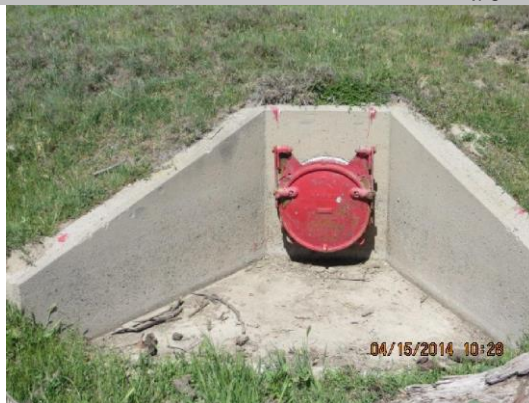
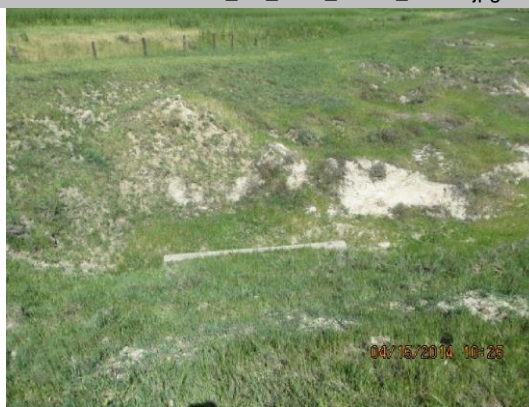
LM Start	0.94	Rating **	A/W	Issue No.	35
LM End	0.94	Issue Type +	Ma	Location *	
Category	Supplemental			GPS Latitude/Longitude	
				Start	End
Item	DWR UCIP LMA Responsibility			37.263950 °	37.263950 °
				-120.760572 °	-120.760572 °
DWR ID					
Comment Code					
Inspector Comment					
FS_ID:33725 DS_ID:19897 EP_NO: N/A Repair Type: No Action Needed Crossing Status: Found UCIP Comments: FIELD_STRUCT_DESC: 24-inch corrugated metal gravity drainage pipe through the levee, 11.5 feet below the crown. Flap gate on the waterside (WS) end. Concrete headwall on the landside (LS) end. Concrete U-shaped headwall on the WS end. [Additional Reference(s): DWR Levee Log, 2002. USACE San Joaquin O&M Manual 601.1, 1967, (HLM 0.94)]. FS Date: 4/15/2014

Concrete headwall and flapgate at WS toe.

Concrete headwall and pipe on LS toe.

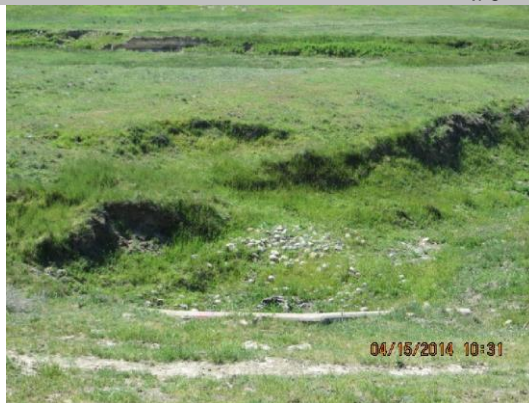
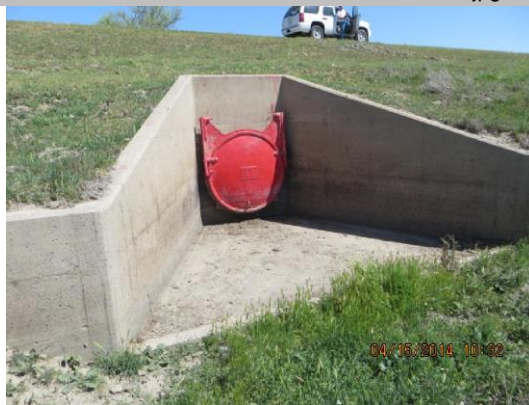
LM Start	1.17	Rating **	A/W	Issue No.	36
LM End	1.17	Issue Type +	Ma	Location *	
Category	Supplemental			GPS Latitude/Longitude	
				Start	End
Item	DWR UCIP LMA Responsibility			37.264421 °	37.264421 °
				-120.756683 °	-120.756683 °
DWR ID					
Comment Code					
Inspector Comment					
FS_ID:33726					
DS_ID:19898					
EP_NO: N/A					
Repair Type: No Action Needed					
Crossing Status: Found					
UCIP Comments:					
FIELD_STRUCT_DESC: 48-inch corrugated metal gravity drainage pipe					
through the levee, 14.6 feet below the crown. Flap gate on the					
waterside (WS) end. Concrete U-shaped headwall on each end.					
[Additional Reference(s): DWR Levee Log, 2002. USACE San Joaquin					
O&M Manual 601.1, 1967, (HLM 1.17)].					
FS Date: 4/15/2014

Pipe, flapgate, and headwall on WS toe.

Flapgate at headwall on WS toe.

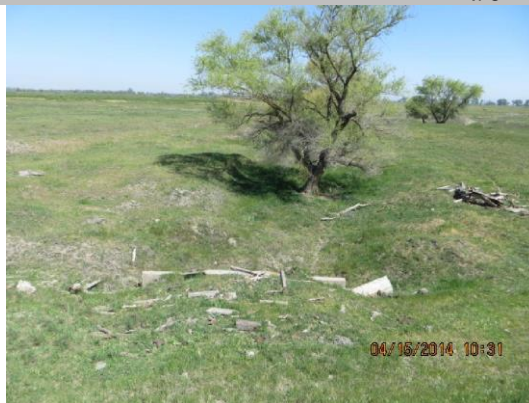
Photo 3 of 3 : UCIP\_SP\_2018\_33726\_60997.jpg

LM Start	1.17	Rating **	A/W	Issue No.	36 (cont)	
LM End	1.17	Issue Type +	Ma	Location *		
Category	Supplemental			GPS Latitude/Longitude		
				Start	End	
Item	DWR UCIP LMA Responsibility			37.264421 °	37.264421 °	
				-120.756683 °	-120.756683 °	
DWR ID						
Comment Code						
Inspector Comment						
FS_ID:33726						
DS_ID:19898						
EP_NO: N/A						
Repair Type: No Action Needed						
Crossing Status: Found						
UCIP Comments:						
FIELD_STRUCT_DESC: 48-inch corrugated metal gravity drainage pipe						
through the levee, 14.6 feet below the crown. Flap gate on the						
waterside (WS) end. Concrete U-shaped headwall on each end.						
[Additional Reference(s): DWR Levee Log, 2002. USACE San Joaquin						
O&M Manual 601.1, 1967, (HLM 1.17)].						
FS Date: 4/15/2014

Pipe and headwall on LS toe.

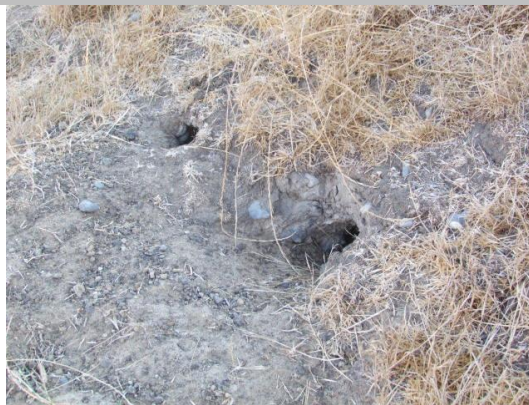
Photo 1 of 2 : SP\_2018\_NA0010\_125\_1\_20180307\_00001.jpg

LM Start	1.22	Rating **	M	Issue No.	1
LM End	1.22	Issue Type +	Ma	Location *	LS
Category	Earthen Levee			GPS Latitude/Longitude	
				Start	End
Item	Animal Control			37.264387 °	37.264387 °
				-120.755805 °	-120.755805 °
DWR ID	DWR_NA0010_07_f_2012_1				
Comment Code					
A1 : Exterminate rodents and backfill and compact or grout burrows.					
Inspector Comment

Looking north at several rodent holes on landward slope.

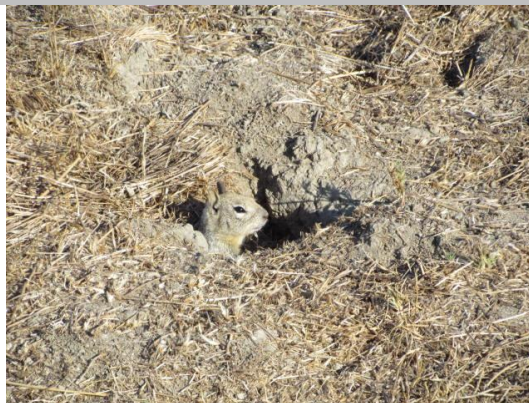
Photo 2 of 2 : SP\_2018\_NA0010\_125\_1\_20180307\_00002.jpg

LM Start	1.22	Rating **	M	Issue No.	1 (cont)	
LM End	1.22	Issue Type +	Ma	Location *	LS	
Category	Earthen Levee			GPS Latitude/Longitude		
				Start		End
Item	Animal Control			37.264387 °		37.264387 °
				-120.755805 °		-120.755805 °
DWR ID	DWR_NA0010_07_f_2012_1					
Comment Code						
A1 : Exterminate rodents and backfill and compact or grout burrows.						
Inspector Comment

Looking at east at active rodent holes on landside berm.

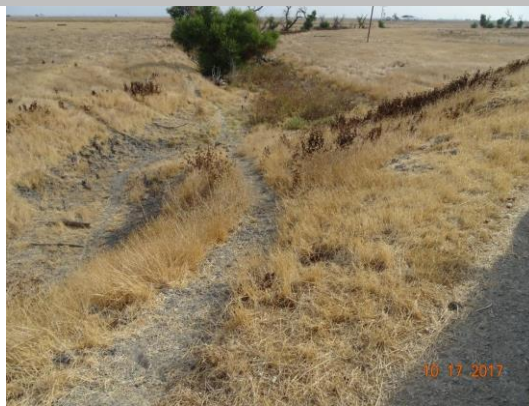
Photo 1 of 1 : SP\_2018\_NA0010\_125\_16\_20180307\_00006.jpg

LM Start	1.49	Rating **	M	Issue No.	16
LM End	1.49	Issue Type +	Ma	Location *	LS
Category	Earthen Levee			GPS Latitude/Longitude	
				Start	End
Item	Slope Stability			37.263999 °	37.263999 °
				-120.750854 °	-120.750854 °
DWR ID	DWR_NA0010_07_f_2017_16				
Comment Code					
S2 : Repair the levee slope damaged by foot traffic and prevent access where possible.					
Inspector Comment					
Repair slope damaged by animal traffic.

Looking east at landside slope.

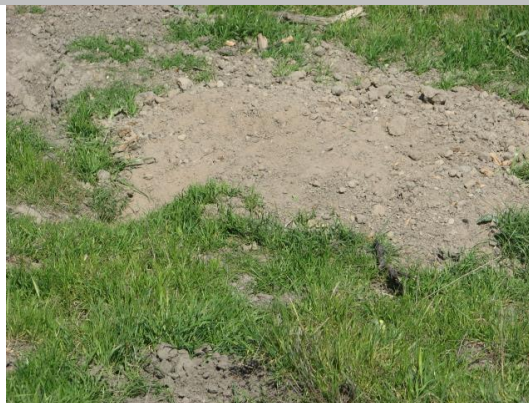
Photo 1 of 2 : SP\_2018\_NA0010\_125\_6\_20180411\_00043.jpg

LM Start	1.50	Rating **	M	Issue No.	6
LM End	1.51	Issue Type +	Ma	Location *	LS
Category	Earthen Levee			GPS Latitude/Longitude	
				Start	End
Item	Animal Control			37.263955 °	37.263885 °
				-120.750751 °	-120.750527 °
DWR ID	DWR_NA0010_07_s_2014_6				
Comment Code					
A1 : Exterminate rodents and backfill and compact or grout burrows.					
Inspector Comment

Looking at typical view of rodent holes within this section. (Spring 2018)

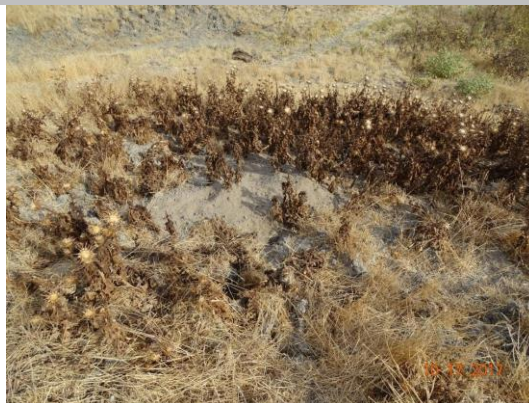
Photo 2 of 2 : SP\_2018\_NA0010\_125\_6\_20180307\_00003.jpg

LM Start	1.50	Rating **	M	Issue No.	6 (cont)	
LM End	1.51	Issue Type +	Ma	Location *	LS	
Category	Earthen Levee			GPS Latitude/Longitude		
				Start		End
Item	Animal Control			37.263955 °		37.263885 °
				-120.750751 °		-120.750527 °
DWR ID	DWR_NA0010_07_s_2014_6					
Comment Code						
A1 : Exterminate rodents and backfill and compact or grout burrows.						
Inspector Comment

Looking northwest at landside slope.

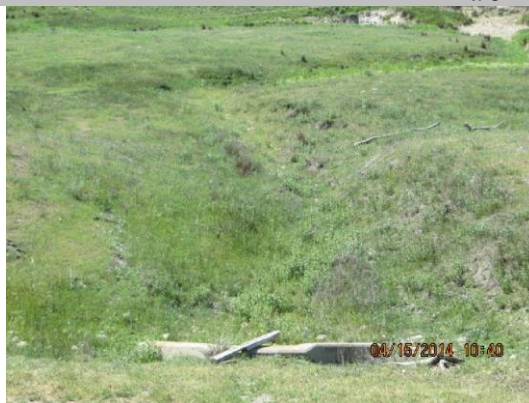
Photo 1 of 3 : UCIP\_SP\_2018\_33727\_61001.jpg

LM Start	1.50	Rating **	A/W	Issue No.	37
LM End	1.50	Issue Type +	Ma	Location *	
Category	Supplemental			GPS Latitude/Longitude	
				Start	End
Item	DWR UCIP LMA Responsibility			37.263917 °	37.263917 °
				-120.750694 °	-120.750694 °
DWR ID					
Comment Code					
Inspector Comment					
FS_ID:33727					
DS_ID:19902					
EP_NO: N/A					
Repair Type: No Action Needed					
Crossing Status: Found					
UCIP Comments:					
FIELD_STRUCT_DESC: 24-inch corrugated metal gravity drainage pipe					
through the levee, 14 feet below the crown. Flap gate on the waterside					
(WS) end. Concrete U-shaped headwall on each end. [Additional					
Reference(s): DWR Levee Log, 2002. USACE San Joaquin O&M					
Manual 601.1, 1967, (HLM 1.51)].					
FS Date: 4/15/2014

Pipe, headwall and flapgate on WS toe.

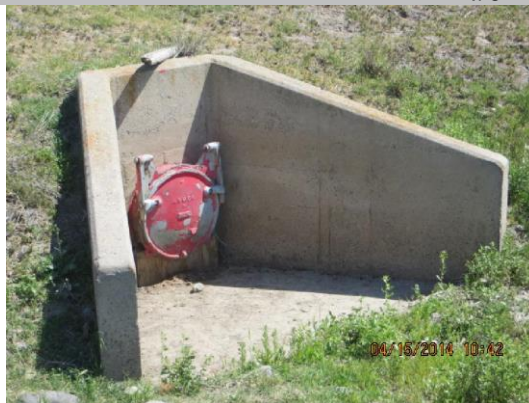
Photo 2 of 3 : UCIP\_SP\_2018\_33727\_61003.jpg

Pipe, headwall and flapgate on WS toe.

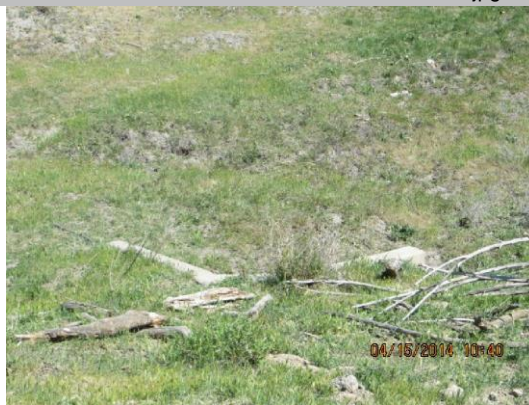
Photo 3 of 3 : UCIP\_SP\_2018\_33727\_61002.jpg

Headwall and pipe on LS toe.

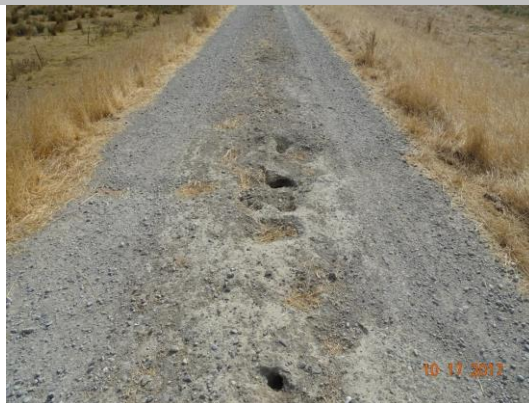
Photo 1 of 1 : SP\_2018\_NA0010\_125\_17\_20180307\_00007.jpg

LM Start	2.12	Rating **	M	Issue No.	17
LM End	2.18	Issue Type +	Ma	Location *	CR
Category	Earthen Levee			GPS Latitude/Longitude	
				Start	End
Item	Animal Control			37.259007 °	37.258726 °
				-120.742050 °	-120.741118 °
DWR ID	DWR_NA0010_07_f_2017_17				
Comment Code					
A3 : No rodents visible, but rodent burrows visible; need to backfill and compact or grout burrows.					
Inspector Comment

Looking southeast at the crown.

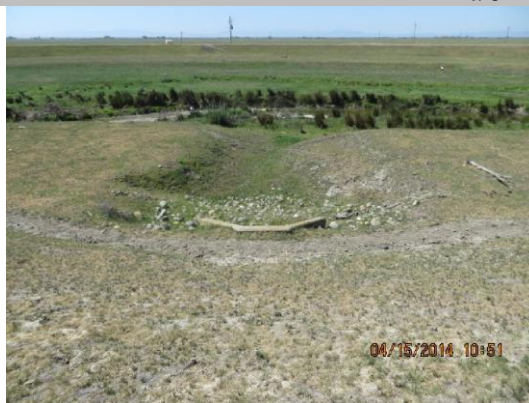
Photo 1 of 3 : UCIP\_SP\_2018\_33728\_61006.jpg

LM Start	2.48	Rating **	A/W	Issue No.	38
LM End	2.48	Issue Type +	Ma	Location *	
Category	Supplemental			GPS Latitude/Longitude	
				Start	End
Item	DWR UCIP LMA Responsibility			37.255803 °	37.255803 °
				-120.737246 °	-120.737246 °
DWR ID					
Comment Code					
Inspector Comment					
FS_ID:33728					
DS_ID:19899					
EP_NO: N/A					
Repair Type: No Action Needed					
Crossing Status: Found					
UCIP Comments:					
FIELD_STRUCT_DESC: 24-inch corrugated metal gravity drainage pipe through the levee, 9.5 feet below the crown. Flap gate on the waterside (WS) end. Concrete headwall on the landside (LS) end. Concrete U-shaped headwall on the WS end. [Additional Reference(s): DWR Levee Log, 2002. USACE San Joaquin O&M Manual 601.1, 1967, (HLM 2.48)].					
FS Date: 4/15/2014

Headwall and flapgate on WS toe.

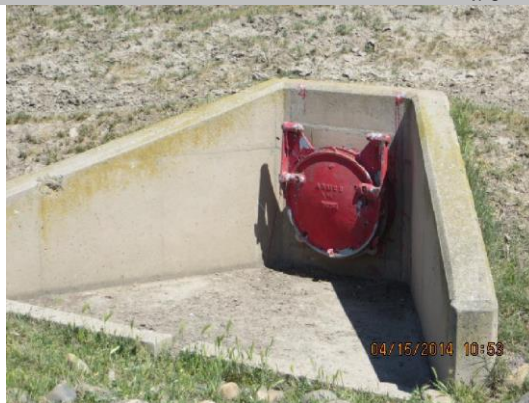
Photo 2 of 3 : UCIP\_SP\_2018\_33728\_61008.jpg

Concrete headwall and flapgate at WS toe.

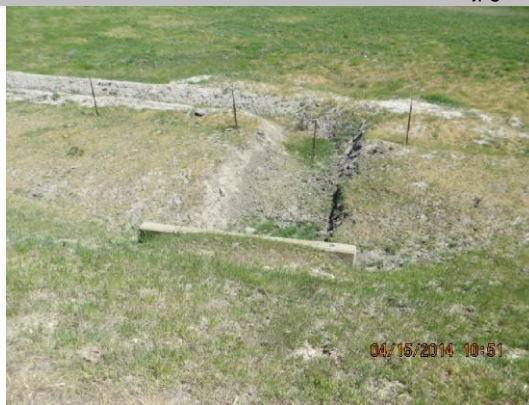
Photo 3 of 3 : UCIP\_SP\_2018\_33728\_61007.jpg

Concrete headwall and pipe on LS toe.

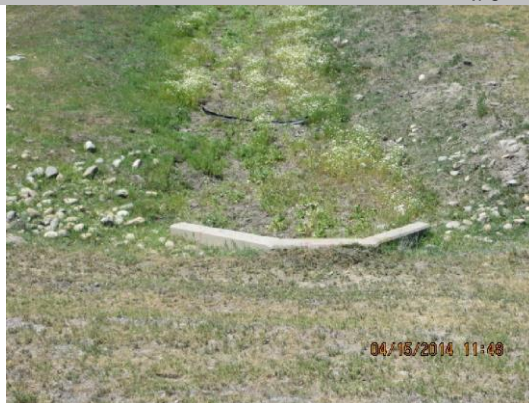
Photo 1 of 3 : UCIP\_SP\_2018\_33729\_61011.jpg

LM Start	2.63	Rating **	A/W	Issue No.	39
LM End	2.63	Issue Type +	Ma	Location *	
Category	Supplemental			GPS Latitude/Longitude	
				Start	End
Item	DWR UCIP LMA Responsibility			37.254832 °	37.254832 °
				-120.734918 °	-120.734918 °
DWR ID					
Comment Code					
Inspector Comment					
FS_ID:33729 DS_ID:19900 EP_NO: N/A Repair Type: No Action Needed Crossing Status: Found UCIP Comments: FIELD_STRUCT_DESC: 24-inch corrugated metal gravity drainage pipe through the levee, 11.5 feet below the crown. Flap gate on the waterside (WS) end. Concrete headwall on the landside (LS) end. Concrete U-shaped headwall on the WS end. [Additional Reference(s): DWR Levee Log, 2002. USACE San Joaquin O&M Manual 601.1, 1967, (HLM 2.64)]. FS Date: 4/15/2014

Concrete headwall and flapgate on WS toe.

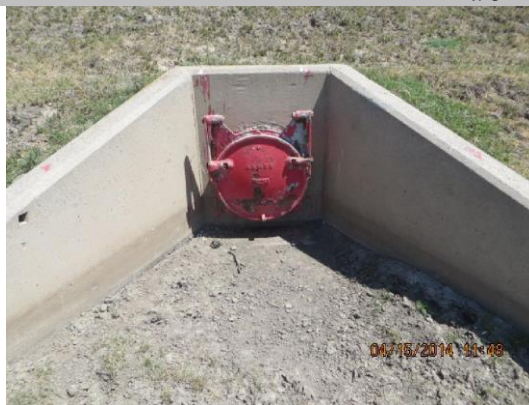
Photo 2 of 3 : UCIP\_SP\_2018\_33729\_61010.jpg

Concrete headwall and flapgate on WS toe.

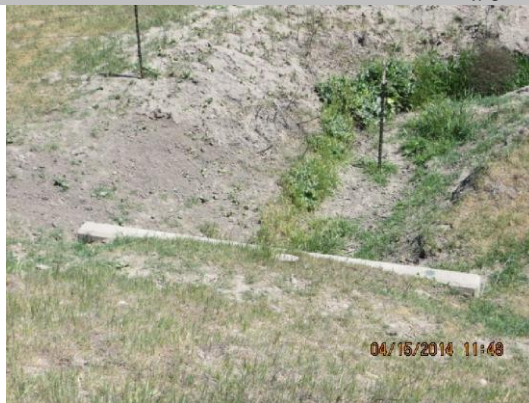
Photo 3 of 3 : UCIP\_SP\_2018\_33729\_61012.jpg

Concrete headwall and pipe at LS toe.

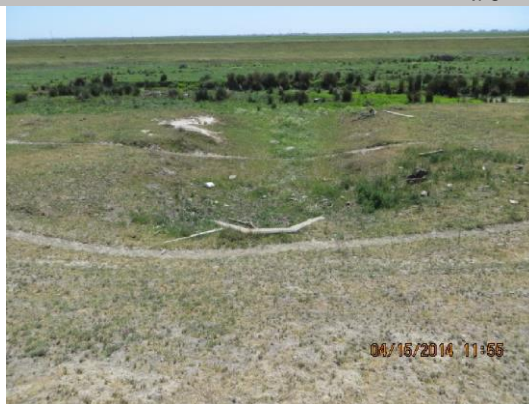
Photo 1 of 3 : UCIP\_SP\_2018\_39508\_61016.jpg

LM Start	3.09	Rating **	M	Issue No.	40
LM End	3.09	Issue Type +	Ma	Location *	
Category	Supplemental			GPS Latitude/Longitude	
				Start	End
Item	DWR UCIP LMA Responsibility			37.251883 °	37.251883 °
				-120.728264 °	-120.728264 °
DWR ID					
Comment Code					
Inspector Comment					
FS_ID:39508 DS_ID:19901 EP_NO: N/A Repair Type: Non-Urgent Crossing Status: Found UCIP Comments: Some sediment buildup at landward toe and inside pipe--recommend clearing. FIELD_STRUCT_DESC: 24-inch corrugated metal gravity drainage pipe through the levee, 10.4 feet below the crown. Flap gate on the waterside (WS) end. Concrete headwall on the landside (LS) end. Concrete U-shaped headwall on the WS end. [Additional Reference(s): DWR Levee Log, 2002. USACE San Joaquin O&M Manual 601.1, 1967, (HLM 3.09)]. FS Date: 4/15/2014

Headwall, pipe, and flapgate on WS toe.

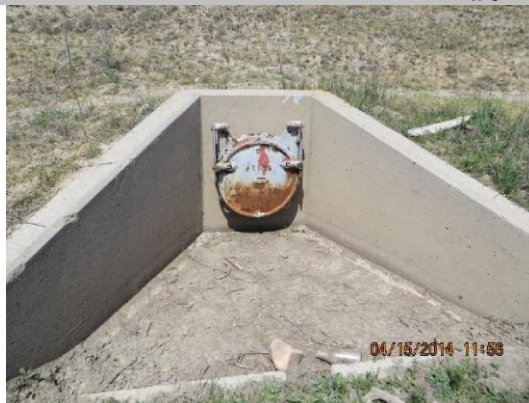
Photo 2 of 3 : UCIP\_SP\_2018\_39508\_61015.jpg

Headwall, pipe, and flapgate on WS toe.

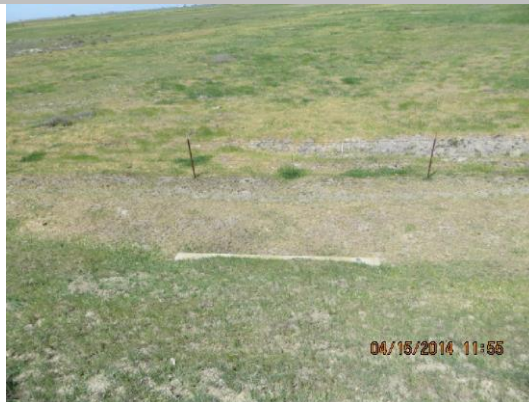
Photo 3 of 3 : UCIP\_SP\_2018\_39508\_61017.jpg

Headwall and pipe on LS toe.

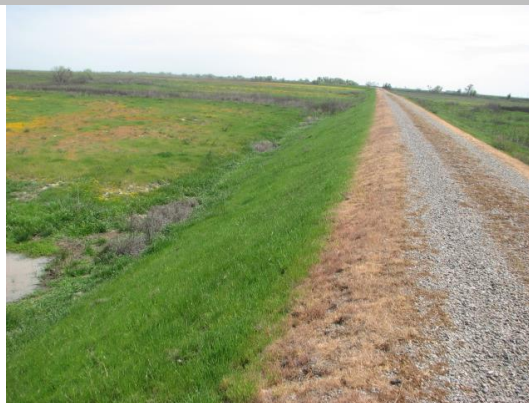
Photo 1 of 1 : SP\_2018\_NA0010\_126\_20\_20180411\_00043.jpg

LM Start	0.00	Rating **	M	Issue No.	20
LM End	3.63	Issue Type +	Ma	Location *	LS
Category	Earthen Levee			GPS Latitude/Longitude	
				Start	End
Item	Vegetation			37.253103 °	37.254137 °
				-120.768464 °	-120.718851 °
DWR ID	DWR_NA0010_08_s_2018_20				
Comment Code					
V1 : Control annual grass and weeds on the levee slopes and easements.					
Inspector Comment

Looking east at typical view of landward slope. (Spring 2018)

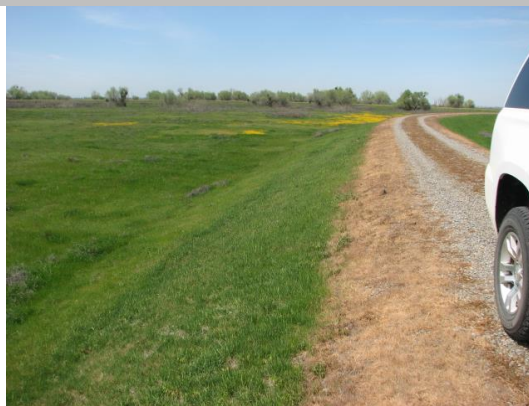
Photo 1 of 1 : SP\_2018\_NA0010\_126\_21\_20180411\_00044.jpg

LM Start	0.00	Rating **	M	Issue No.	21
LM End	3.63	Issue Type +	Ma	Location *	WS
Category	Earthen Levee			GPS Latitude/Longitude	
				Start	End
Item	Vegetation			37.253104°	37.254136°
				-120.768464°	-120.718851°
DWR ID	DWR_NA0010_08_s_2018_21				
Comment Code					
V1 : Control annual grass and weeds on the levee slopes and easements.					
Inspector Comment

Looking west at typical view of waterward slope. (Spring 2018)

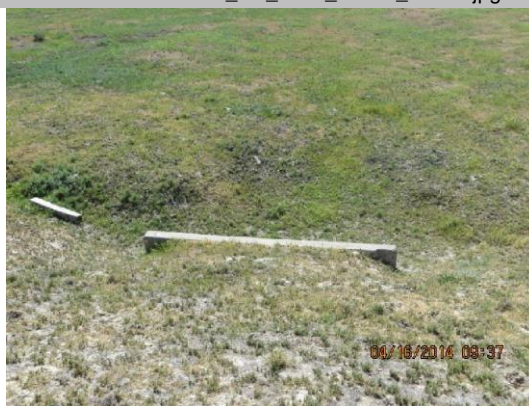
Photo 3 of 3 : UCIP\_SP\_2018\_33751\_61069.jpg

LM Start	0.23	Rating **	A/W	Issue No.	22 (cont)	
LM End	0.23	Issue Type +	Ma	Location *		
Category	Supplemental			GPS Latitude/Longitude		
				Start		End
Item	DWR UCIP LMA Responsibility			37.256092 °	37.256092 °	
				-120.767873 °	-120.767873 °	
DWR ID						
Comment Code						
Inspector Comment						
FS_ID:33751 DS_ID:19903 EP_NO: N/A Repair Type: No Action Needed Crossing Status: Found UCIP Comments: FIELD_STRUCT_DESC: 24-inch corrugated metal gravity drainage pipe through the levee, 9.6 feet below the crown. Flap gate on the waterside (WS) end. Concrete headwall on the landside (LS) end. Concrete U-shaped headwall on the WS end. [Additional Reference(s): DWR Levee Log, 2002. USACE San Joaquin O&M Manual 601.1, 1967, (HLM 0.23)]. FS Date: 4/16/2014

Concrete headwall on LS toe.

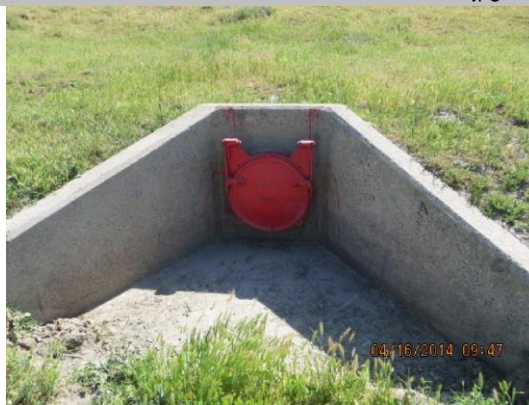
Photo 2 of 3 : UCIP\_SP\_2018\_33752\_61072.jpg

Pipe, flapgate and headwall on WS toe.

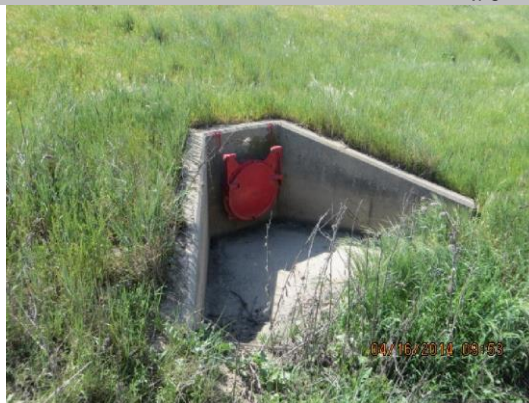
Photo 2 of 3 : UCIP\_SP\_2018\_33753\_61080.jpg

LM Start	0.72	Rating **	A/W	Issue No.	24 (cont)	
LM End	0.72	Issue Type +	Ma	Location *		
Category	Supplemental			GPS Latitude/Longitude		
				Start	End	
Item	DWR UCIP LMA Responsibility			37.260306 °	37.260306 °	
				-120.762127 °	-120.762127 °	
DWR ID						
Comment Code						
Inspector Comment						
FS_ID:33753						
DS_ID:19905						
EP_NO: N/A						
Repair Type: No Action Needed						
Crossing Status: Found						
UCIP Comments:						
FIELD_STRUCT_DESC: 24-inch corrugated metal gravity drainage pipe through the levee, 10 feet below the crown. Flap gate on the waterside (WS) end. Concrete headwall on each end. [Additional Reference(s): DWR Levee Log, 2002. USACE San Joaquin O&M Manual 601.1, 1967, (HLM 0.72)].						
FS Date: 4/16/2014

Headwall and flapgate at WS toe.

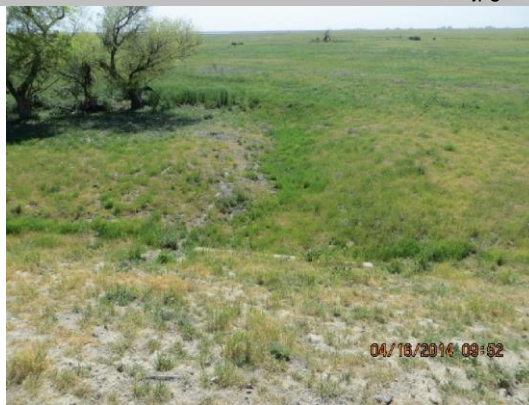
Photo 3 of 3 : UCIP\_SP\_2018\_33753\_61079.jpg

Concrete headwall on LS toe.

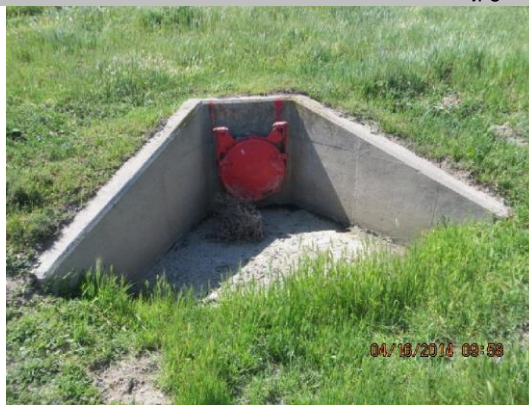
Photo 2 of 3 : UCIP\_SP\_2018\_39887\_61083.jpg

Headwall, pipe, and flapgate on WS toe.

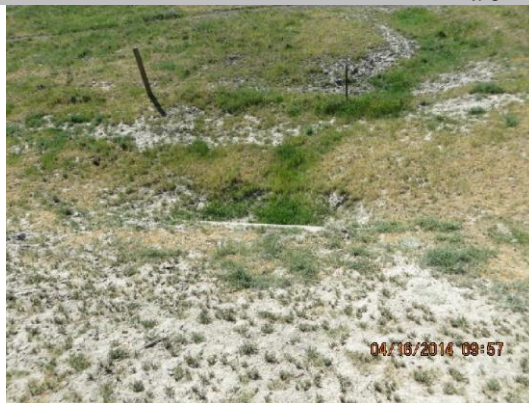
Photo 3 of 3 : UCIP\_SP\_2018\_39887\_61085.jpg

LM Start	0.90	Rating **	M	Issue No.	25 (cont)	
LM End	0.90	Issue Type +	Ma	Location *		
Category	Supplemental			GPS Latitude/Longitude		
				Start	End	
Item	DWR UCIP LMA Responsibility			37.262384 °	37.262384 °	
				-120.760528 °	-120.760528 °	
DWR ID						
Comment Code						
Inspector Comment						
FS_ID:39887						
DS_ID:19832						
EP_NO: N/A						
Repair Type: Non-Urgent						
Crossing Status: Found						
UCIP Comments: Some sediment buildup at inlet on LS toe.						
FIELD_STRUCT_DESC: 24-inch corrugated metal gravity drainage pipe						
through the levee, 11.5 feet below the crown. Flap gate on the						
waterside (WS) end. Concrete headwall on each end. [Additional						
Reference(s): DWR Levee Log, 2002. USACE San Joaquin O&M						
Manual 601.1, 1967, (HLM 0.89)].						
FS Date: 4/16/2014

Pipe and headwall on LS toe.

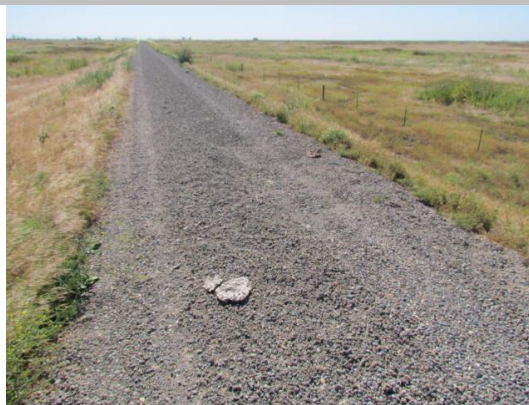
Photo 1 of 1 : SP\_2018\_NA0010\_126\_5\_20180307\_00004.jpg

LM Start	1.16	Rating **	A/W	Issue No.	5
LM End	3.18	Issue Type +	Ma	Location *	CR
Category	Earthen Levee			GPS Latitude/Longitude	
				Start	End
Item	Crown Surface / Depressions / Rutting			37.263243 °	37.251737 °
				-120.756372 °	-120.726246 °
DWR ID	DWR_NA0010_08_s_2016_5				
Comment Code					
C2 : Repair depressions or ruts in the crown or slope.					
Inspector Comment					
Depression noted on levee crown.

Looking west at depression on toward landward shoulder.

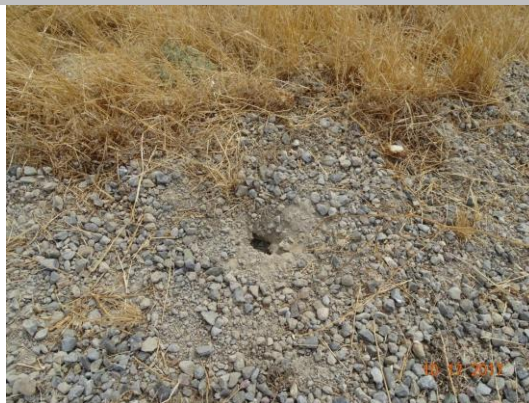
Photo 1 of 1 : SP\_2018\_NA0010\_126\_2\_20180307\_00001.jpg

LM Start	1.20	Rating **	M	Issue No.	2
LM End	1.20	Issue Type +	Ma	Location *	LS
Category	Earthen Levee			GPS Latitude/Longitude	
				Start	End
Item	Animal Control			37.263182 °	37.263183 °
				-120.755650 °	-120.755637 °
DWR ID	DWR_NA0010_08_s_2012_2				
Comment Code					
A3 : No rodents visible, but rodent burrows visible; need to backfill and compact or grout burrows.					
Inspector Comment

Looking south at the landside shoulder.

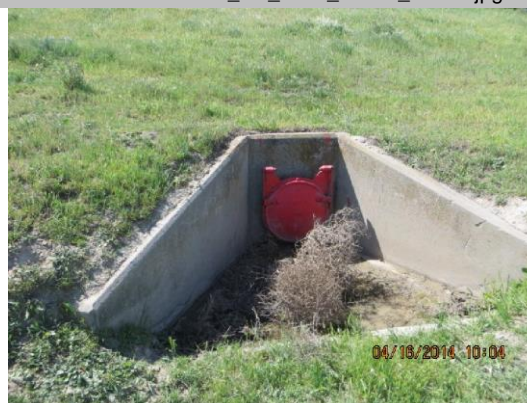
Photo 2 of 3 : UCIP\_SP\_2018\_39509\_61091.jpg

LM Start	1.21	Rating **	M	Issue No.	26 (cont)	
LM End	1.21	Issue Type +	Ma	Location *		
Category	Supplemental			GPS Latitude/Longitude		
				Start		End
Item	DWR UCIP LMA Responsibility			37.263188 °		37.263188 °
				-120.755399 °		-120.755399 °
DWR ID						
Comment Code						
Inspector Comment						
FS_ID:39509 DS_ID:19833 EP_NO: N/A Repair Type: Non-Urgent Crossing Status: Found UCIP Comments: Debris blocking landward headwall--recommend clearing. FIELD_STRUCT_DESC: 24-inch corrugated metal gravity drainage pipe through the levee, 11.6 feet below the crown. Flap gate on the waterside (WS) end. Concrete headwall on each end. [Additional Reference(s): DWR Levee Log, 2002. USACE San Joaquin O&M Manual 601.1, 1967, (HLM 1.21)]. FS Date: 4/16/2014

Concrete headwall, pipe, and flapgate on WS toe.

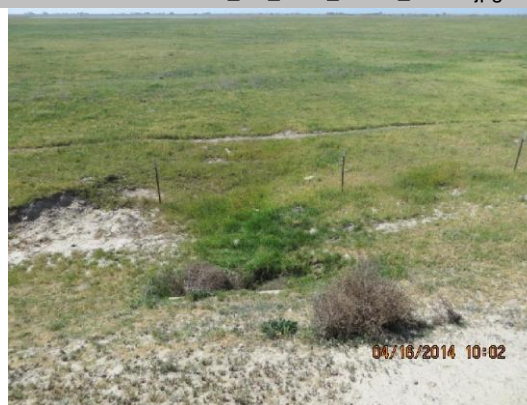
Photo 3 of 3 : UCIP\_SP\_2018\_39509\_61089.jpg

Pipe and headwall on LS toe.

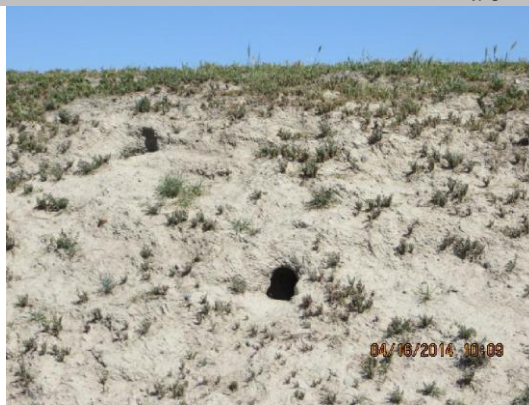
Photo 3 of 3 : UCIP\_SP\_2018\_39510\_61095.jpg

Animal burrows along alignment on LS slope.

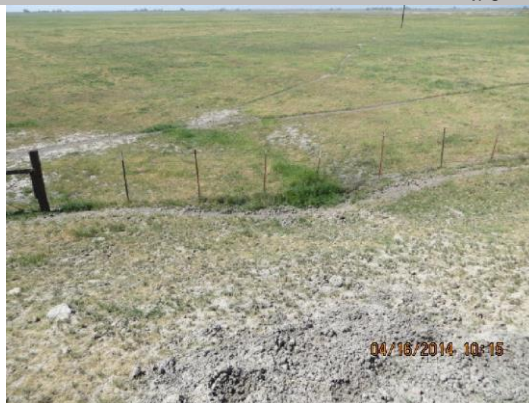
Photo 2 of 3 : UCIP\_SP\_2018\_39511\_61099.jpg

LM Start	2.05	Rating **	M	Issue No.	28 (cont)	
LM End	2.05	Issue Type +	Ma	Location *		
Category	Supplemental			GPS Latitude/Longitude		
				Start	End	
Item	DWR UCIP LMA Responsibility			37.258220 °	37.258220 °	
				-120.742868 °	-120.742868 °	
DWR ID						
Comment Code						
Inspector Comment						
FS_ID:39511 DS_ID:19835 EP_NO: N/A Repair Type: Non-Urgent Crossing Status: Found UCIP Comments: Non-functional landward inlet is buried in sediment. Need to contact owner to determine status. FIELD_STRUCT_DESC: 24-inch corrugated metal gravity drainage pipe through the levee, 12 feet below the crown. Flap gate on the waterside (WS) end. Concrete headwall on each end. [Additional Reference(s): DWR Levee Log, 2002. USACE San Joaquin O&M Manual 601.1, 1967, (HLM 2.05)]. FS Date: 4/16/2014

Pipe and headwall buried in sediment at LS toe.

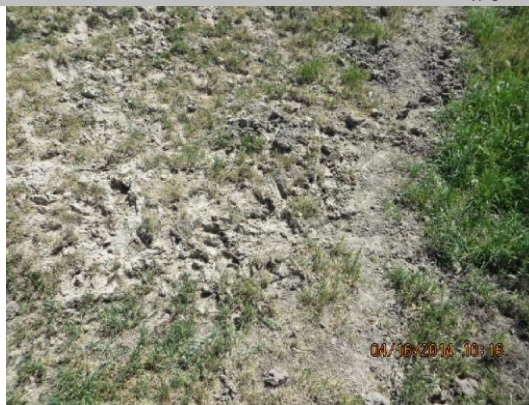
Photo 3 of 3 : UCIP\_SP\_2018\_39511\_61097.jpg

Pipe and headwall buried in sediment at LS toe.

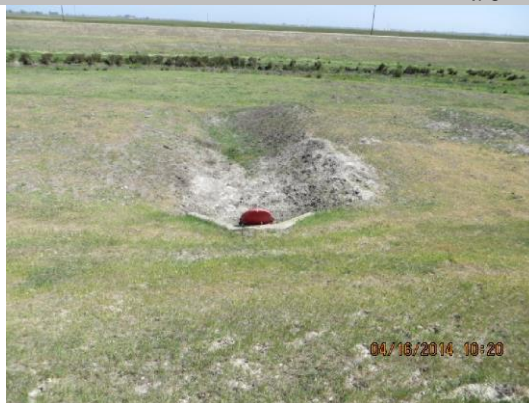
Photo 1 of 3 : UCIP\_SP\_2018\_39512\_61102.jpg

LM Start	2.12	Rating **	M	Issue No.	29
LM End	2.12	Issue Type +	Ma	Location *	
Category	Supplemental			GPS Latitude/Longitude	
				Start	End
Item	DWR UCIP LMA Responsibility			37.257800 °	37.257800 °
				-120.741604 °	-120.741604 °
DWR ID					
Comment Code					
Inspector Comment					
FS_ID:39512					
DS_ID:19836					
EP_NO: N/A					
Repair Type: Non-Urgent					
Crossing Status: Found					
UCIP Comments: Sediment buildup in pipe visible from landward side.					
FIELD_STRUCT_DESC: 24-inch corrugated metal gravity drainage pipe					
through the levee, 9.5 feet below the crown. Flap gate on the waterside					
(WS) end. Concrete headwall on each end. [Additional Reference(s):					
DWR Levee Log, 2002. USACE San Joaquin O&M Manual 601.1, 1967,					
(HLM 2.12)].					
FS Date: 4/16/2014

Pipe, headwall, and flapgate on WS toe.

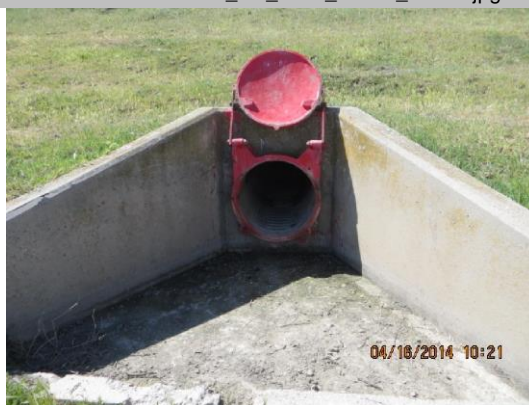
Photo 2 of 3 : UCIP\_SP\_2018\_39512\_61100.jpg

Pipe, headwall, and flapgate on WS toe.

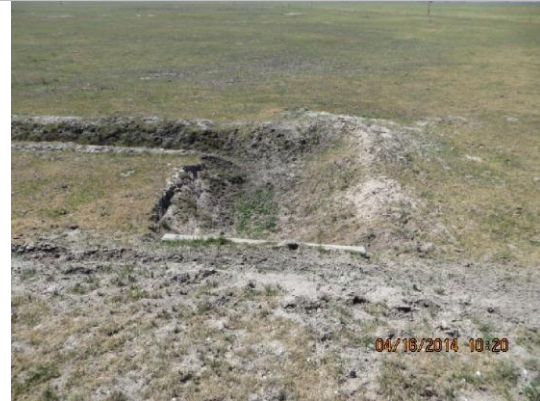
Photo 3 of 3 : UCIP\_SP\_2018\_39512\_61101.jpg

Pipe and headwall on LS toe.

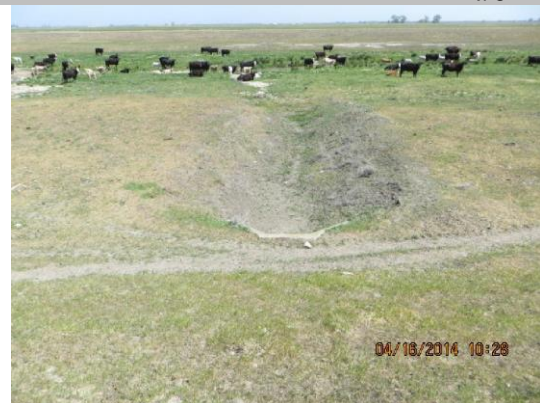
Photo 1 of 3 : UCIP\_SP\_2018\_33760\_61107.jpg

LM Start	2.77	Rating **	A/W	Issue No.	30
LM End	2.77	Issue Type +	Ma	Location *	
Category	Supplemental			GPS Latitude/Longitude	
				Start	End
Item	DWR UCIP LMA Responsibility			37.252228 °	37.252228 °
				-120.732890 °	-120.732890 °
DWR ID					
Comment Code					
Inspector Comment					
FS_ID:33760					
DS_ID:19837					
EP_NO: N/A					
Repair Type: No Action Needed					
Crossing Status: Found					
UCIP Comments:					
FIELD_STRUCT_DESC: 24-inch corrugated metal gravity drainage pipe					
through the levee, 10.5 feet below the crown. Flap gate on the					
waterside (WS) end. Concrete headwall on each end. [Additional					
Reference(s): DWR Levee Log, 2002. USACE San Joaquin O&M					
Manual 601.1, 1967, (HLM 2.77)].					
FS Date: 4/16/2014

Pipe, headwall, and flapgate on Ws toe.

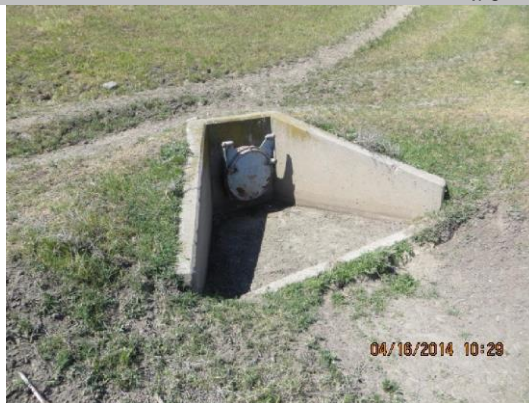
Photo 2 of 3 : UCIP\_SP\_2018\_33760\_61105.jpg

Pipe, headwall, and flapgate on Ws toe.

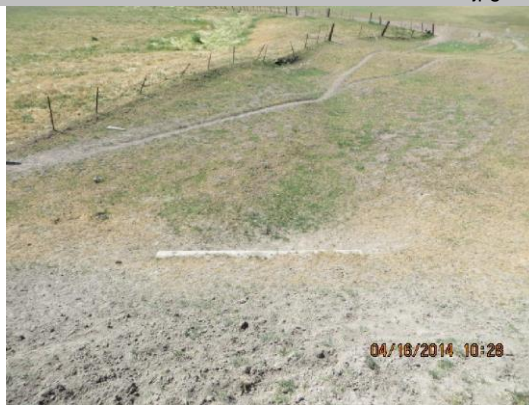
Photo 3 of 3 : UCIP\_SP\_2018\_33760\_61106.jpg

Pipe and headwall on LS toe.

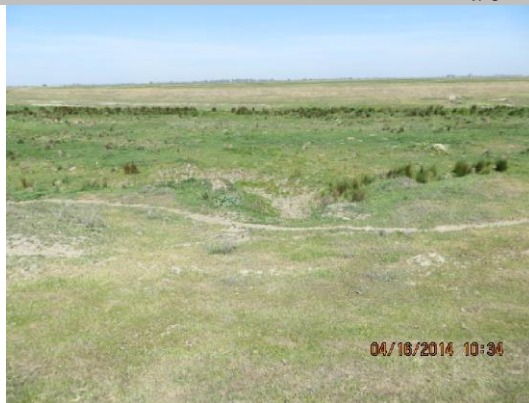
Photo 1 of 3 : UCIP\_SP\_2018\_49969\_61112.jpg

Comment Code					
Inspector Comment					
FS_ID:49969 DS_ID:19838 EP_NO: N/A Repair Type: Non-Urgent Crossing Status: Found UCIP Comments: 7/20/2016 LS inlet buried under dense vegetation. Dense vegetation limits the inspector's visibility to identify signs of pipe failure (leaks) along the WS and LS slope. Recommend removing vegetation along pipe alignment to conduct proper inspection of structure and appurtenances. (DWR UCIP - omagana)4/16/2014 Pipe blocked by silt on LS toe. Flapgate rusty and does not operate correctly. (DWR UCIP - omagana) FIELD_STRUCT_DESC: 36-inch corrugated metal gravity drainage pipe through the levee, 13.4 feet below the crown. Flap gate on the waterside (WS) end. Concrete headwall on each end. [Additional Reference(s): DWR Levee Log, 2002. USACE San Joaquin O&M Manual 601.1, 1967, (HLM 3.06)]. FS Date: 7/20/2016

Pipe, headwall, and flapgate on WS toe.

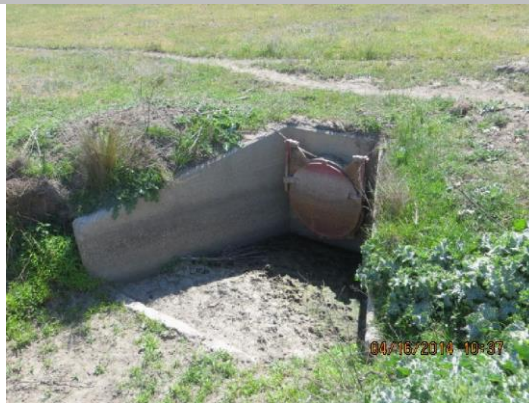
Photo 2 of 3 : UCIP\_SP\_2018\_49969\_61113.jpg

Pipe, headwall, and flapgate on WS toe.
