**Flood Control Project Maintenance  
Levee Inspections**  
**LMA District Cover Sheet**  
**Spring 2018 Levee Inspection Results**

**Lower San Joaquin Levee District**

**Spring 2018 Levee Inspection Results**

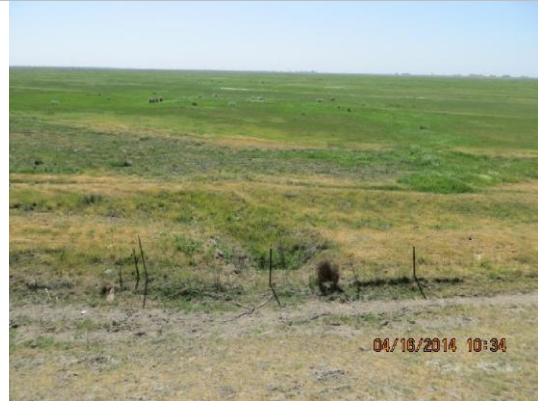
Photo 3 of 3 : UCIP\_SP\_2018\_49969\_61111.jpg

Comment Code					
Inspector Comment					
FS_ID:49969 DS_ID:19838 EP_NO: N/A Repair Type: Non-Urgent Crossing Status: Found UCIP Comments: 7/20/2016 LS inlet buried under dense vegetation. Dense vegetation limits the inspector's visibility to identify signs of pipe failure (leaks) along the WS and LS slope. Recommend removing vegetation along pipe alignment to conduct proper inspection of structure and appurtenances. (DWR UCIP - omagana)4/16/2014 Pipe blocked by silt on LS toe. Flapgate rusty and does not operate correctly. (DWR UCIP - omagana) FIELD_STRUCT_DESC: 36-inch corrugated metal gravity drainage pipe through the levee, 13.4 feet below the crown. Flap gate on the waterside (WS) end. Concrete headwall on each end. [Additional Reference(s): DWR Levee Log, 2002. USACE San Joaquin O&M Manual 601.1, 1967, (HLM 3.06)]. FS Date: 7/20/2016

Pipe and headwall on LS toe.

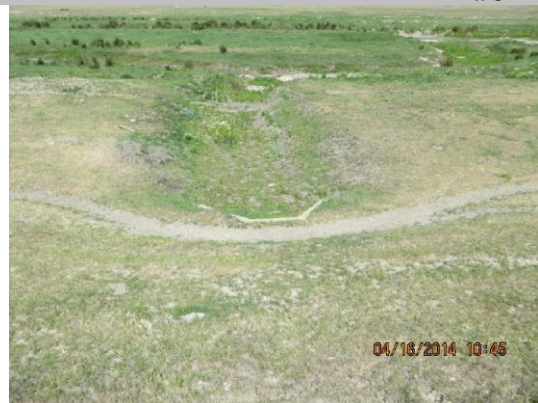
Photo 1 of 3 : UCIP\_SP\_2018\_33764\_61128.jpg

LM Start	3.24	Rating **	A/W	Issue No.	32
LM End	3.24	Issue Type +	Ma	Location *	
Category	Supplemental			GPS Latitude/Longitude	
				Start	End
Item	DWR UCIP LMA Responsibility			37.252230 °	37.252230 °
				-120.725504 °	-120.725504 °
DWR ID					
Comment Code					
Inspector Comment					
FS_ID:33764					
DS_ID:19839					
EP_NO: N/A					
Repair Type: No Action Needed					
Crossing Status: Found					
UCIP Comments:					
FIELD_STRUCT_DESC: 24-inch corrugated metal gravity drainage pipe					
through the levee, 10 feet below the crown. Flap gate on the waterside					
(WS) end. Concrete headwall on each end. [Additional Reference(s):					
DWR Levee Log, 2002. USACE San Joaquin O&M Manual 601.1, 1967,					
(HLM 3.24)].					
FS Date: 4/16/2014

Pipe, flapgate, and headwall on WS toe.

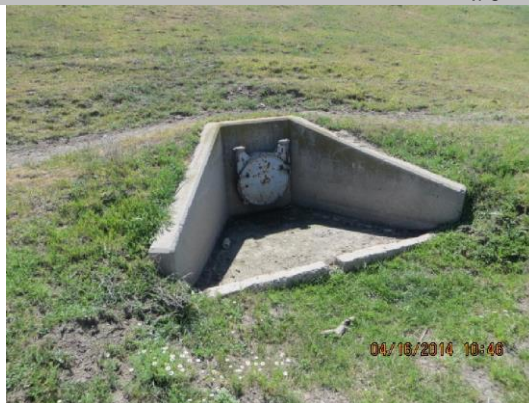
Photo 2 of 3 : UCIP\_SP\_2018\_33764\_61127.jpg

Pipe, flapgate, and headwall on WS toe.

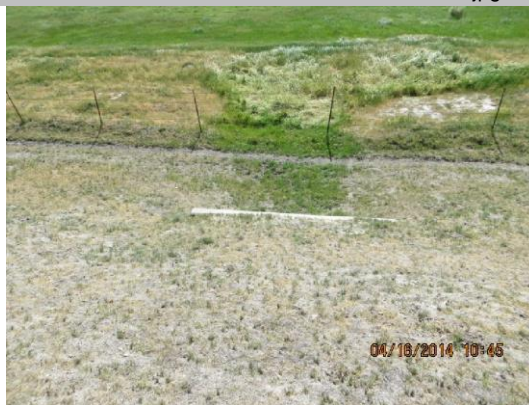
Photo 3 of 3 : UCIP\_SP\_2018\_33764\_61129.jpg

Pipe and headwall on LS toe.

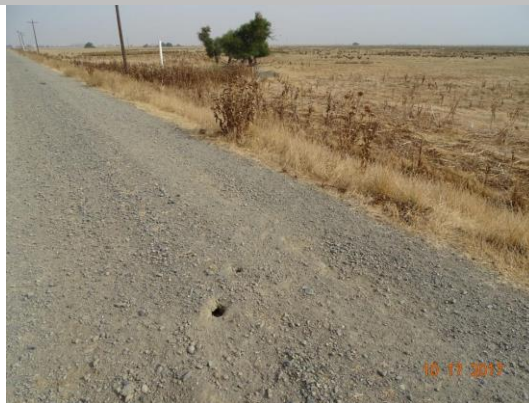
Photo 1 of 2 : SP\_2018\_NA0010\_126\_3\_20180307\_00002.jpg

Looking east at the crown towards the landside.

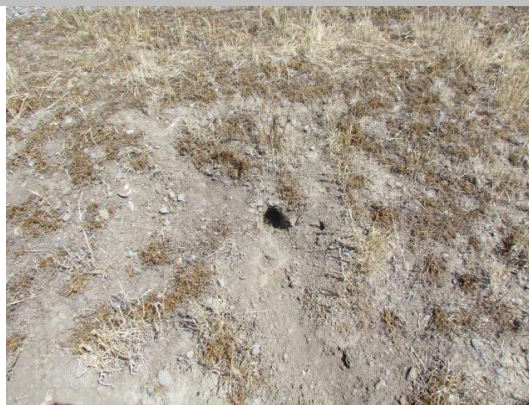
Photo 2 of 2 : SP\_2018\_NA0010\_126\_3\_20180307\_00003.jpg

LM Start	3.40	Rating **	M	Issue No.	3
LM End	3.54	Issue Type +	Ma	Location *	LS
Category	Earthen Levee			GPS Latitude/Longitude	
				Start	End
Item	Animal Control			37.253052 °	37.253600 °
				-120.722647 °	-120.720198 °
DWR ID	DWR_NA0010_08_s_2012_3				
Comment Code					
A3 : No rodents visible, but rodent burrows visible; need to backfill and compact or grout burrows.					
Inspector Comment					
Noted several rodent holes on landside slope within this reach.

Looking at typical view of rodent holes on landward slope.

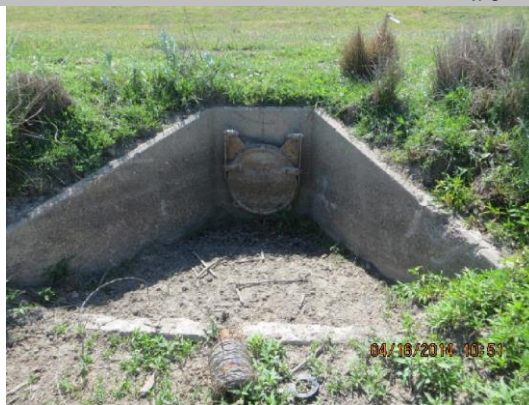
Photo 2 of 3 : UCIP\_SP\_2018\_39513\_61133.jpg

Pipe, headwall, and flapgate on WS toe.

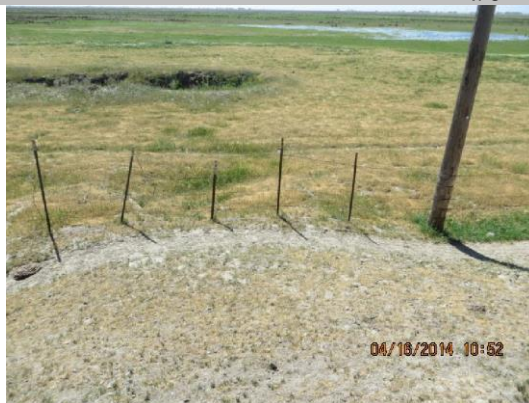
Photo 3 of 3 : UCIP\_SP\_2018\_39513\_61132.jpg

Pipe likely at drainage swale off LS toe.

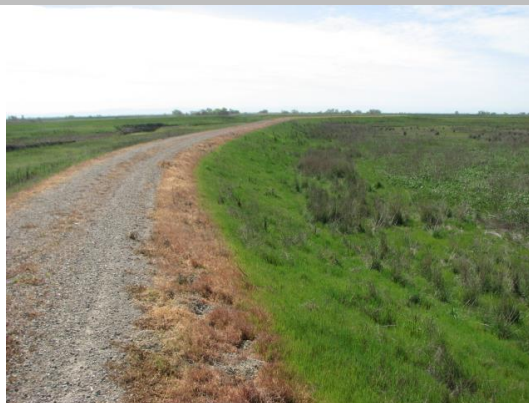
Photo 1 of 1 : SP\_2018\_NA0010\_127\_5\_20180411\_00012.jpg

LM Start	0.00	Rating **	M	Issue No.	5
LM End	0.86	Issue Type +	Ma	Location *	LS
Category	Earthen Levee			GPS Latitude/Longitude	
				Start	End
Item	Vegetation			37.220222 °	37.220051 °
				-120.713000 °	-120.698417 °
DWR ID	DWR_NA0010_09_s_2018_5				
Comment Code					
V1 : Control annual grass and weeds on the levee slopes and easements.					
Inspector Comment

Looking downstream at typical view of landward slope. (Spring 2018)

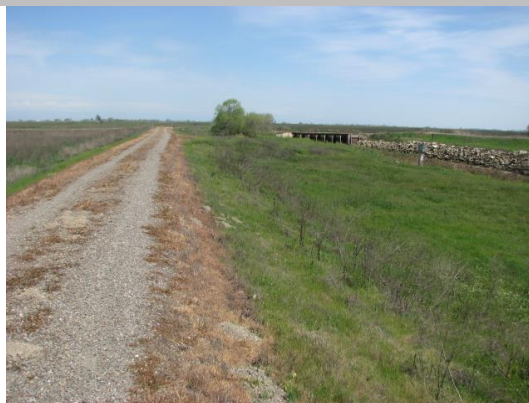
Photo 1 of 1 : SP\_2018\_NA0010\_127\_6\_20180411\_00011.jpg

LM Start	0.00	Rating **	M	Issue No.	6
LM End	0.86	Issue Type +	Ma	Location *	WS
Category	Earthen Levee			GPS Latitude/Longitude	
				Start	End
Item	Vegetation			37.220222 °	37.220051 °
				-120.713000 °	-120.698417 °
DWR ID	DWR_NA0010_09_s_2018_6				
Comment Code					
V1 : Control annual grass and weeds on the levee slopes and easements.					
Inspector Comment

Looking downstream at typical view of waterward slope. (Spring 2018)

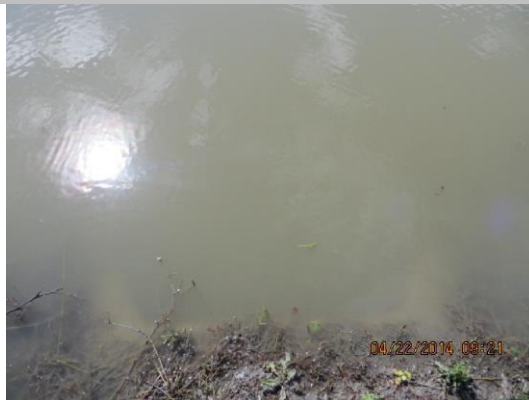
Photo 2 of 3 : UCIP\_SP\_2018\_39888\_62117.jpg

Concrete headwall visible under water on WS toe.

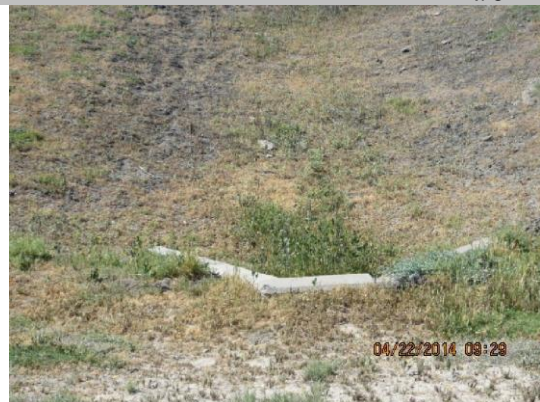
Photo 1 of 3 : UCIP\_SP\_2018\_39515\_62128.jpg

LM Start	0.69	Rating **	M	Issue No.	8
LM End	0.69	Issue Type +	Ma	Location *	
Category	Supplemental			GPS Latitude/Longitude	
				Start	End
Item	DWR UCIP LMA Responsibility			37.219874 °	37.219874 °
				-120.701438 °	-120.701438 °
DWR ID					
Comment Code					
Inspector Comment					
FS_ID:39515 DS_ID:19842 EP_NO: N/A Repair Type: Non-Urgent Crossing Status: Found UCIP Comments: Animal burrows in area on LS slope. Minor sediment buildup in pipe visible on landward side--recommend clearing. FIELD_STRUCT_DESC: 24-inch corrugated metal gravity drainage pipe through the levee, 8.7 feet below the crown. Flap gate on the waterside (WS) end. Concrete headwall on the landside (LS) end. Concrete U-shaped headwall on the WS end. [Additional Reference(s): DWR Levee Log, 2002. USACE San Joaquin O&M Manual 601.1, 1967, (HLM 0.70)]. FS Date: 4/22/2014

Headwall, flapgate, and pipe on WS toe.

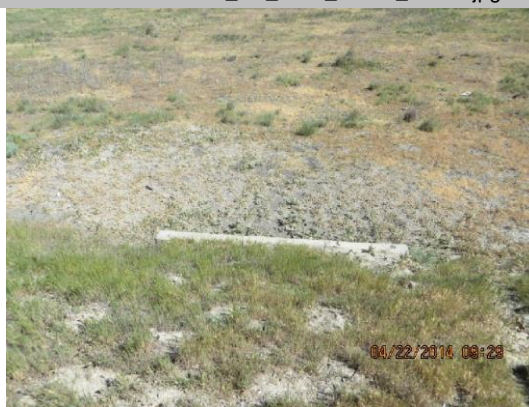
Photo 3 of 3 : UCIP\_SP\_2018\_39515\_62129.jpg

LM Start	0.69	Rating **	M	Issue No.	8 (cont)	
LM End	0.69	Issue Type +	Ma	Location *		
Category	Supplemental			GPS Latitude/Longitude		
				Start		End
Item	DWR UCIP LMA Responsibility			37.219874 °		37.219874 °
				-120.701438 °		-120.701438 °
DWR ID						
Comment Code						
Inspector Comment						
FS_ID:39515 DS_ID:19842 EP_NO: N/A Repair Type: Non-Urgent Crossing Status: Found UCIP Comments: Animal burrows in area on LS slope. Minor sediment buildup in pipe visible on landward side--recommend clearing. FIELD_STRUCT_DESC: 24-inch corrugated metal gravity drainage pipe through the levee, 8.7 feet below the crown. Flap gate on the waterside (WS) end. Concrete headwall on the landside (LS) end. Concrete U-shaped headwall on the WS end. [Additional Reference(s): DWR Levee Log, 2002. USACE San Joaquin O&M Manual 601.1, 1967, (HLM 0.70)]. FS Date: 4/22/2014

Headwall and pipe on LS toe.

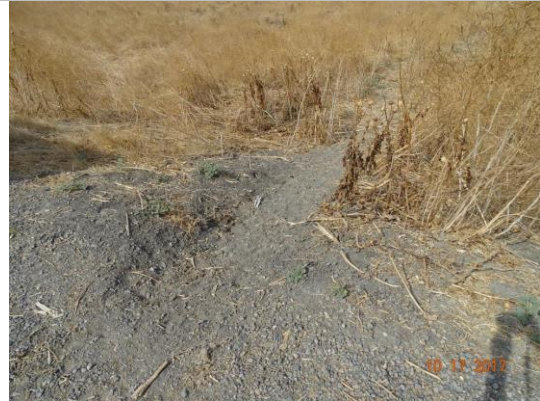
Photo 1 of 1 : SP\_2018\_NA0010\_127\_4\_20180307\_00001.jpg

LM Start	0.86	Rating **	M	Issue No.	4
LM End	0.86	Issue Type +	Ma	Location *	LS
Category	Earthen Levee			GPS Latitude/Longitude	
				Start	End
Item	Slope Stability			37.220041 °	37.220041 °
				-120.698425 °	-120.698425 °
DWR ID	DWR_NA0010_09_f _ 2017_4				
Comment Code					
S2 : Repair the levee slope damaged by foot traffic and prevent access where possible.					
Inspector Comment

Looking northwest at landside slope.

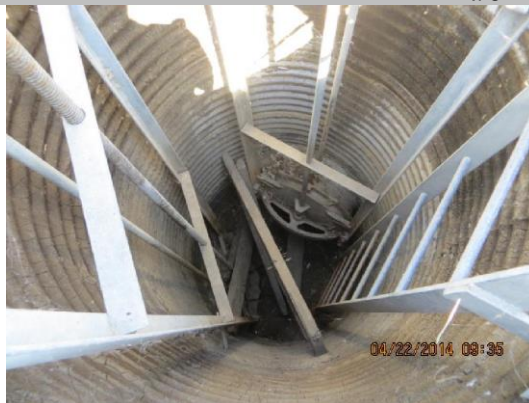
Photo 2 of 3 : UCIP\_SP\_2018\_34186\_62133.jpg

LM Start	0.87	Rating **	A/W	Issue No.	9 (cont)	
LM End	0.87	Issue Type +	Ma	Location *		
Category	Supplemental			GPS Latitude/Longitude		
				Start		End
Item	DWR UCIP LMA Responsibility			37.220051 °	37.220051 °	
				-120.698374 °	-120.698374 °	
DWR ID						
Comment Code						
Inspector Comment						
FS_ID:34186 DS_ID:19843 EP_NO: N/A Repair Type: No Action Needed Crossing Status: Found UCIP Comments: FIELD_STRUCT_DESC: 24-inch corrugated metal gravity drainage pipe through the levee, 9.7 feet below the crown. Two slide gates in a 48-inch corrugated metal pipe (CMP) riser on the waterside (WS) slope. Concrete U-shaped headwall on the landside (LS) end. WS end cobble revetted on the bank and in the outlet drain. [Additional Reference(s): DWR Levee Log, 2002. USACE San Joaquin O&M Manual 601.1, 1967, (HLM 0.87)]. FS Date: 4/22/2014

Inside CMP riser on WS slope.

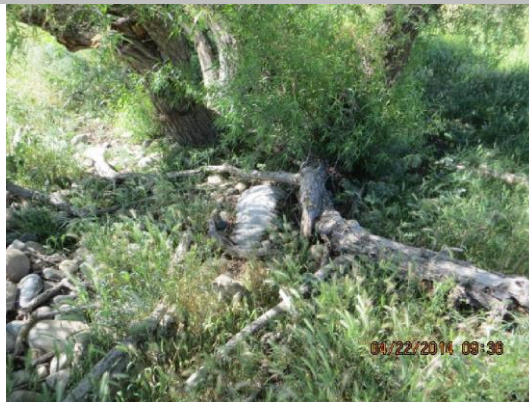
Photo 3 of 3 : UCIP\_SP\_2018\_34186\_62137.jpg

Outlet at WS toe.

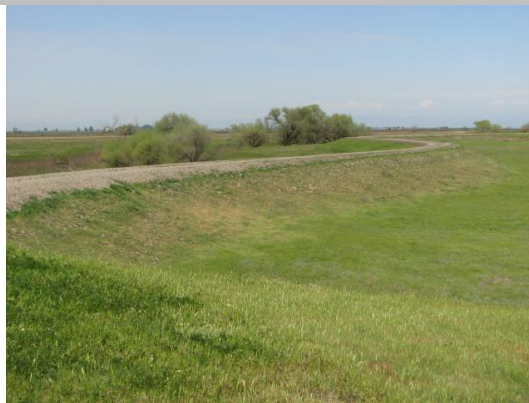
Photo 1 of 1 : SP\_2018\_NA0010\_128\_3\_20180411\_00005.jpg

LM Start	0.00	Rating **	M	Issue No.	3
LM End	0.78	Issue Type +	Ma	Location *	LS
Category	Earthen Levee			GPS Latitude/Longitude	
				Start	End
Item	Vegetation			37.217893 °	37.219331 °
				-120.711456 °	-120.698171 °
DWR ID	DWR_NA0010_10_s _ 2018_3				
Comment Code					
V1 : Control annual grass and weeds on the levee slopes and easements.					
Inspector Comment					
LMA to maintain vegetation on LS slope.

Looking upstream at typical view of landward slope. (Spring 2018)

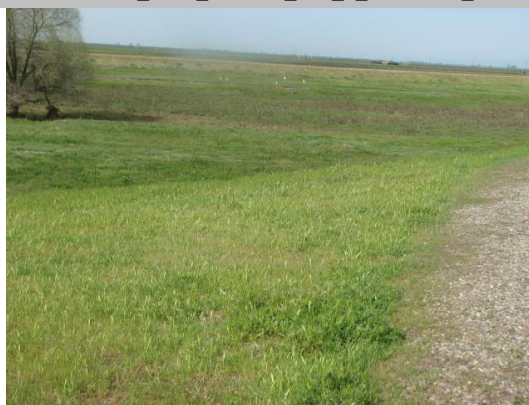
Photo 1 of 1 : SP\_2018\_NA0010\_128\_4\_20180411\_00006.jpg

LM Start	0.00	Rating **	M	Issue No.	4
LM End	0.78	Issue Type +	Ma	Location *	WS
Category	Earthen Levee			GPS Latitude/Longitude	
				Start	End
Item	Vegetation			37.217893 °	37.219335 °
				-120.711456 °	-120.698172 °
DWR ID	DWR_NA0010_10_s _ 2018_4				
Comment Code					
V1 : Control annual grass and weeds on the levee slopes and easements.					
Inspector Comment					
LMA to maintain vegetation on WS slope.

Looking northeast at typical view of waterward slope. (Spring 2018)

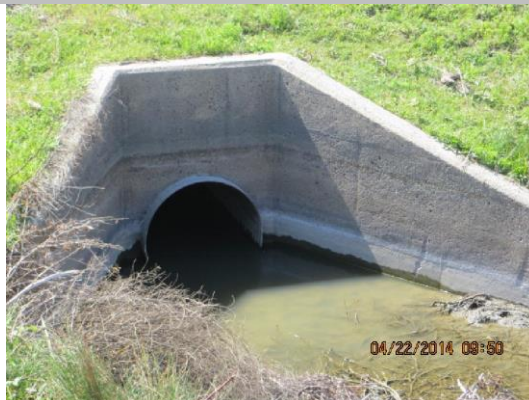
Photo 2 of 3 : UCIP\_SP\_2018\_39516\_62146.jpg

Headwall and pipe on WS toe.

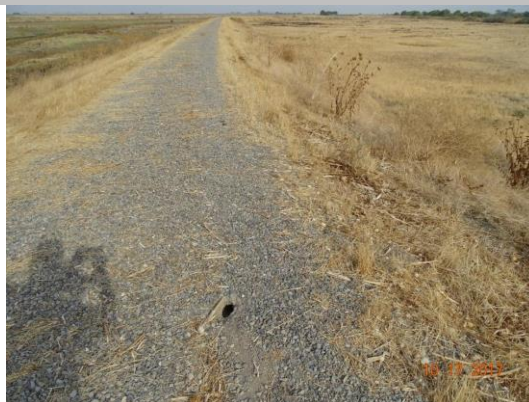
Photo 1 of 1 : SP\_2018\_NA0010\_128\_2\_20180307\_00001.jpg

LM Start	0.32	Rating **	A/W	Issue No.	2
LM End	0.32	Issue Type +	Ma	Location *	CR
Category	Earthen Levee			GPS Latitude/Longitude	
				Start	End
Item	Animal Control			37.219192 °	37.219192 °
				-120.706295 °	-120.706295 °
DWR ID	DWR_NA0010_10_f_2017_2				
Comment Code					
A1 : Exterminate rodents and backfill and compact or grout burrows.					
Inspector Comment

Looking west at the crown.

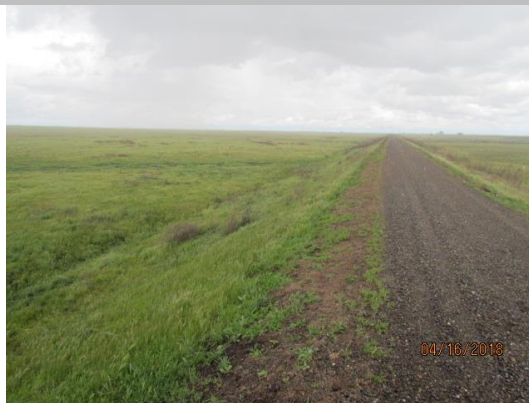
Photo 1 of 1 : SP\_2018\_NA0010\_129\_10\_20180420\_00024.jpg

LM Start	0.00	Rating **	M	Issue No.	10
LM End	3.31	Issue Type +	Ma	Location *	LS
Category	Earthen Levee			GPS Latitude/Longitude	
				Start	End
Item	Vegetation			37.202749 °	37.202321 °
				-120.755184 °	-120.695304 °
DWR ID	DWR_NA0010_11_s_2018_10				
Comment Code					
V1 : Control annual grass and weeds on the levee slopes and easements.					
Inspector Comment

Looking south at typical view of landward slope. (Spring 2018)

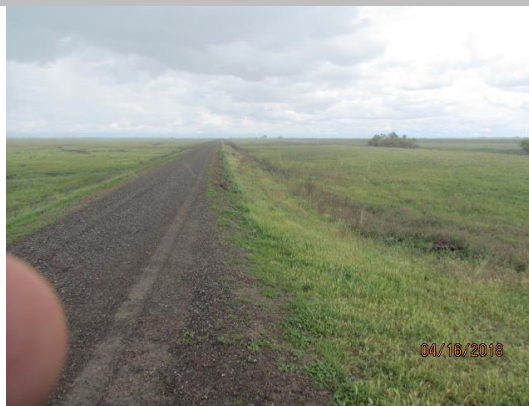
Photo 1 of 1 : SP\_2018\_NA0010\_129\_11\_20180420\_00023.jpg

LM Start	0.00	Rating **	M	Issue No.	11
LM End	3.31	Issue Type +	Ma	Location *	WS
Category	Earthen Levee			GPS Latitude/Longitude	
				Start	End
Item	Vegetation			37.202749 °	37.202321 °
				-120.755184 °	-120.695304 °
DWR ID	DWR_NA0010_11_s_2018_11				
Comment Code					
V1 : Control annual grass and weeds on the levee slopes and easements.					
Inspector Comment

Looking south at typical view of waterward slope. (Spring 2018)

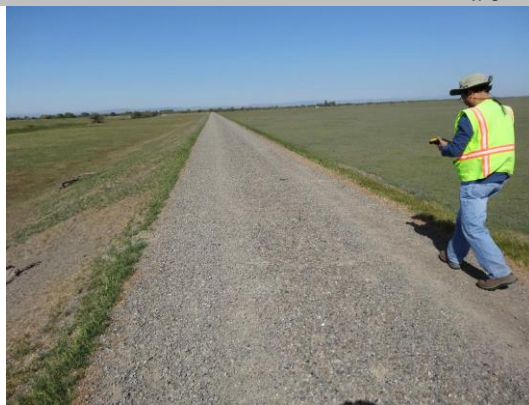
Photo 2 of 3 : UCIP\_SP\_2018\_39517\_66643.jpg

View of levee crown at crossing.

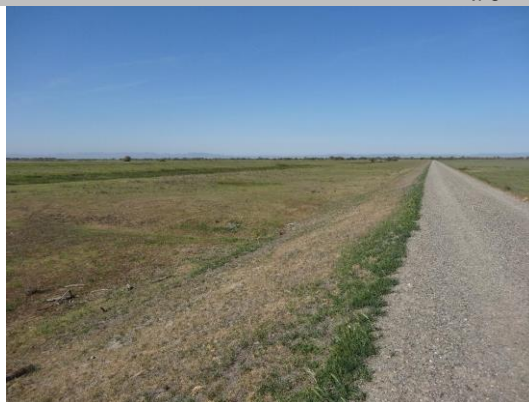
Photo 1 of 3 : UCIP\_SP\_2018\_39518\_61997.jpg

LM Start	0.65	Rating **	M	Issue No.	13
LM End	0.65	Issue Type +	Ma	Location *	
Category	Supplemental			GPS Latitude/Longitude	
				Start	End
Item	DWR UCIP LMA Responsibility			37.202751 °	37.202751 °
				-120.743474 °	-120.743474 °
DWR ID					
Comment Code					
Inspector Comment					
FS_ID:39518					
DS_ID:19847					
EP_NO: N/A					
Repair Type: Non-Urgent					
Crossing Status: Found					
UCIP Comments: Need to contact owner. Recommend clearing					
sediment deposit inside pipe.					
FIELD_STRUCT_DESC: 24-inch corrugated metal gravity drainage pipe					
through the levee, 10 feet below the crown. Flap gate on the waterside					
(WS) end. [Additional Reference(s): DWR Levee Log, 2002. USACE					
San Joaquin O&M Manual 601.1, 1967, (HLM 0.65)].					
FS Date: 4/18/2014

View of waterward side.

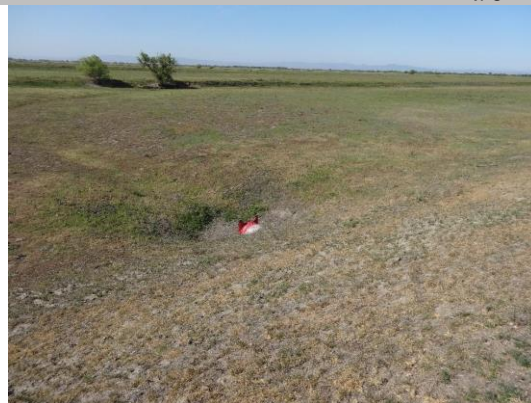
Photo 1 of 3 : UCIP\_SP\_2018\_39519\_62003.jpg

LM Start	0.84	Rating **	M	Issue No.	14
LM End	0.84	Issue Type +	Ma	Location *	
Category	Supplemental			GPS Latitude/Longitude	
				Start	End
Item	DWR UCIP LMA Responsibility			37.202745 °	37.202745 °
				-120.739935 °	-120.739935 °
DWR ID					
Comment Code					
Inspector Comment					
FS_ID:39519					
DS_ID:19848					
EP_NO: N/A					
Repair Type: Non-Urgent					
Crossing Status: Found					
UCIP Comments: Need to contact owner. Recommend clearing sediment deposit inside pipe.					
FIELD_STRUCT_DESC: 24-inch corrugated metal gravity drainage pipe through the levee, 10.3 feet below the crown. Flap gate on the waterside (WS) end. [Additional Reference(s): DWR Levee Log, 2002. USACE San Joaquin O&M Manual 601.1, 1967, (HLM 0.84)].					
FS Date: 4/18/2014

Overview of waterward side.

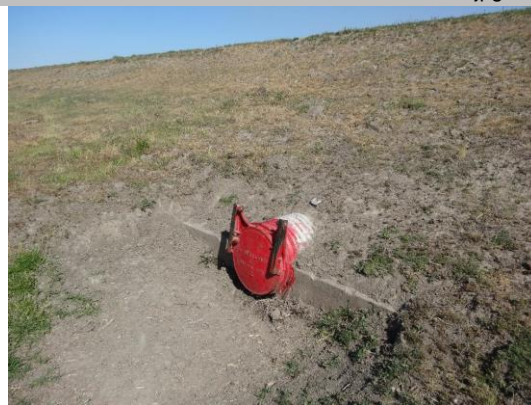
Photo 2 of 3 : UCIP\_SP\_2018\_39519\_62002.jpg

Concrete headwall and flap gate visible on waterward side.

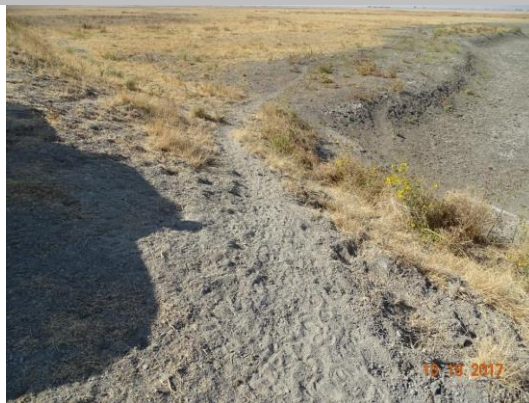
Photo 1 of 1 : SP\_2018\_NA0010\_129\_9\_20180307\_00001.jpg

LM Start	1.49	Rating **	M	Issue No.	9
LM End	1.49	Issue Type +	Ma	Location *	LS
Category	Earthen Levee			GPS Latitude/Longitude	
				Start	End
Item	Slope Stability			37.202748 °	37.202748 °
				-120.728182 °	-120.728182 °
DWR ID	DWR_NA0010_11_f_2017_9				
Comment Code					
S2 : Repair the levee slope damaged by foot traffic and prevent access where possible.					
Inspector Comment

Looking northwest at landside slope.

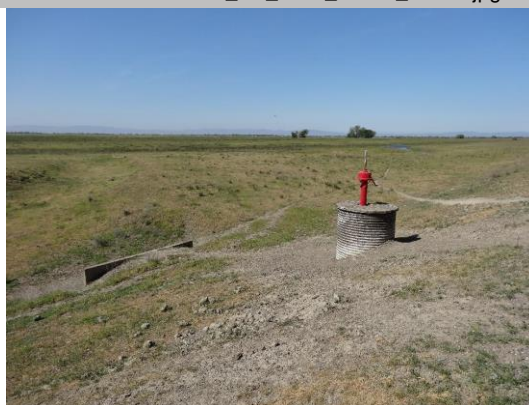
Photo 1 of 3 : UCIP\_SP\_2018\_39521\_62018.jpg

LM Start	1.49	Rating **	M	Issue No.	16
LM End	1.49	Issue Type +	Ma	Location *	
Category	Supplemental			GPS Latitude/Longitude	
				Start	End
Item	DWR UCIP LMA Responsibility			37.202753 °	37.202753 °
				-120.728133 °	-120.728133 °
DWR ID					
Comment Code					
Inspector Comment					
FS_ID:39521					
DS_ID:19850					
EP_NO: N/A					
Repair Type: Non-Urgent					
Crossing Status: Found					
UCIP Comments: Need to contact owner. Recommend clearing sediment deposit inside pipe.					
FIELD_STRUCT_DESC: 48-inch corrugated metal gravity drainage pipe through the levee, 16.3 feet below the crown. Slide gate in a pipe riser on the waterside (WS) slope. [Additional Reference(s): DWR Levee Log, 2002. USACE San Joaquin O&M Manual 601.1, 1967, (HLM 1.50)].					
FS Date: 4/18/2014

View of waterward side.

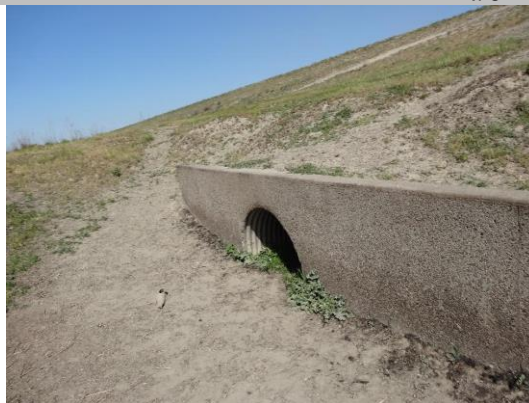
Photo 2 of 3 : UCIP\_SP\_2018\_39521\_62017.jpg

LM Start	1.49	Rating **	M	Issue No.	16 (cont)	
LM End	1.49	Issue Type +	Ma	Location *		
Category	Supplemental			GPS Latitude/Longitude		
				Start	End	
Item	DWR UCIP LMA Responsibility			37.202753 °	37.202753 °	
				-120.728133 °	-120.728133 °	
DWR ID						
Comment Code						
Inspector Comment						
FS_ID:39521						
DS_ID:19850						
EP_NO: N/A						
Repair Type: Non-Urgent						
Crossing Status: Found						
UCIP Comments: Need to contact owner. Recommend clearing						
sediment deposit inside pipe.						
FIELD_STRUCT_DESC: 48-inch corrugated metal gravity drainage pipe						
through the levee, 16.3 feet below the crown. Slide gate in a pipe riser						
on the waterside (WS) slope. [Additional Reference(s): DWR Levee						
Log, 2002. USACE San Joaquin O&M Manual 601.1, 1967, (HLM 1.50)].						
FS Date: 4/18/2014

View of concrete headwall located on waterward side.

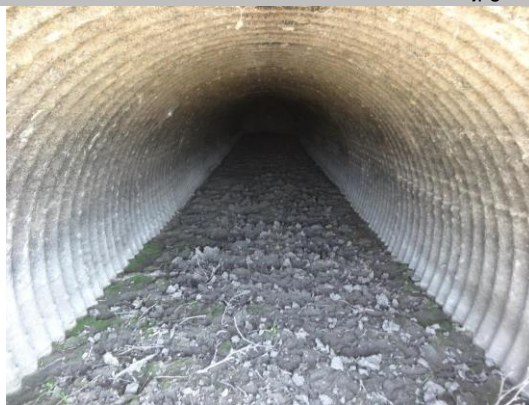
Photo 3 of 3 : UCIP\_SP\_2018\_39521\_62016.jpg

Inside view of pipe from waterward side--sediment build up.

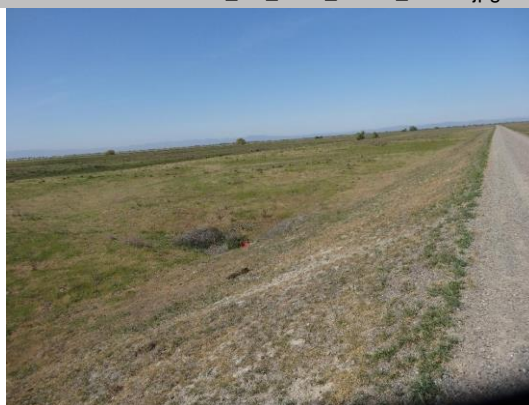
Photo 1 of 3 : UCIP\_SP\_2018\_39522\_62024.jpg

LM Start	1.98	Rating **	M	Issue No.	17
LM End	1.98	Issue Type +	Ma	Location *	
Category	Supplemental			GPS Latitude/Longitude	
				Start	End
Item	DWR UCIP LMA Responsibility			37.202740 °	37.202740 °
				-120.719247 °	-120.719247 °
DWR ID					
Comment Code					
Inspector Comment					
FS_ID:39522					
DS_ID:19851					
EP_NO: N/A					
Repair Type: Non-Urgent					
Crossing Status: Found					
UCIP Comments: Need to contact owner. Recommend clearing sediment deposit inside pipe.					
FIELD_STRUCT_DESC: 24-inch corrugated metal gravity drainage pipe through the levee, 12.8 feet below the crown. Flap gate on the waterside (WS) end. [Additional Reference(s): DWR Levee Log, 2002. USACE San Joaquin O&M Manual 601.1, 1967, (HLM 1.99)].					
FS Date: 4/18/2014

View of waterward side.

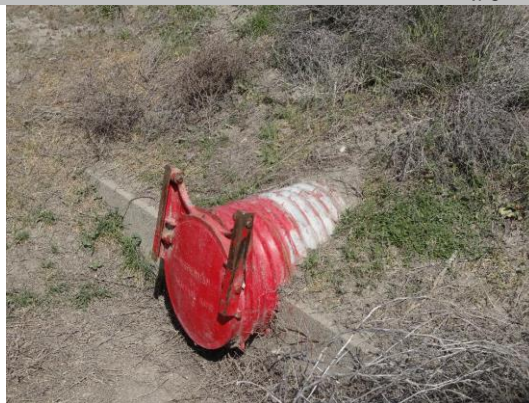
Photo 2 of 3 : UCIP\_SP\_2018\_39522\_62025.jpg

LM Start	1.98	Rating **	M	Issue No.	17 (cont)	
LM End	1.98	Issue Type +	Ma	Location *		
Category	Supplemental			GPS Latitude/Longitude		
				Start	End	
Item	DWR UCIP LMA Responsibility			37.202740 °	37.202740 °	
				-120.719247 °	-120.719247 °	
DWR ID						
Comment Code						
Inspector Comment						
FS_ID:39522						
DS_ID:19851						
EP_NO: N/A						
Repair Type: Non-Urgent						
Crossing Status: Found						
UCIP Comments: Need to contact owner. Recommend clearing						
sediment deposit inside pipe.						
FIELD_STRUCT_DESC: 24-inch corrugated metal gravity drainage pipe						
through the levee, 12.8 feet below the crown. Flap gate on the						
waterside (WS) end. [Additional Reference(s): DWR Levee Log, 2002.						
USACE San Joaquin O&M Manual 601.1, 1967, (HLM 1.99)].						
FS Date: 4/18/2014

Flap gate located on waterward side.

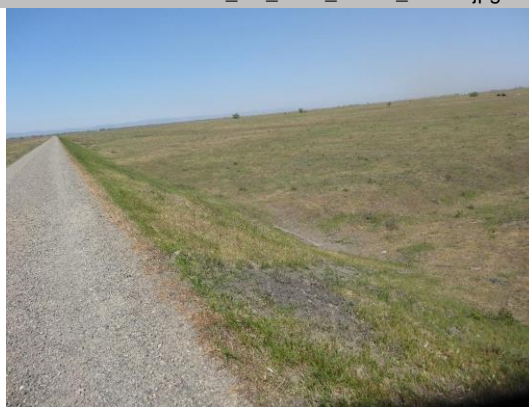
Photo 3 of 3 : UCIP\_SP\_2018\_39522\_62023.jpg

View of landward side.

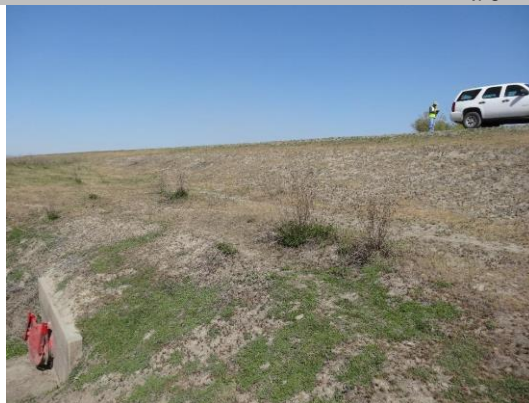
Photo 1 of 3 : UCIP\_SP\_2018\_39523\_62028.jpg

LM Start	3.04	Rating **	M	Issue No.	18
LM End	3.04	Issue Type +	Ma	Location *	
Category	Supplemental			GPS Latitude/Longitude	
				Start	End
Item	DWR UCIP LMA Responsibility			37.202494 °	37.202494 °
				-120.700153 °	-120.700153 °
DWR ID					
Comment Code					
Inspector Comment					
FS_ID:39523					
DS_ID:19852					
EP_NO: N/A					
Repair Type: Non-Urgent					
Crossing Status: Found					
UCIP Comments: Need to contact owner. Recommend clearing sediment deposit inside pipe.					
FIELD_STRUCT_DESC: 24-inch corrugated metal gravity drainage pipe through the levee, 15 feet below the crown. Flap gate on the waterside (WS) end. [Additional Reference(s): DWR Levee Log, 2002. USACE San Joaquin O&M Manual 601.1, 1967, (HLM 3.04)].					
FS Date: 4/18/2014

Overview of waterward side--flap gate, concrete headwall and apron visible on levee toe.

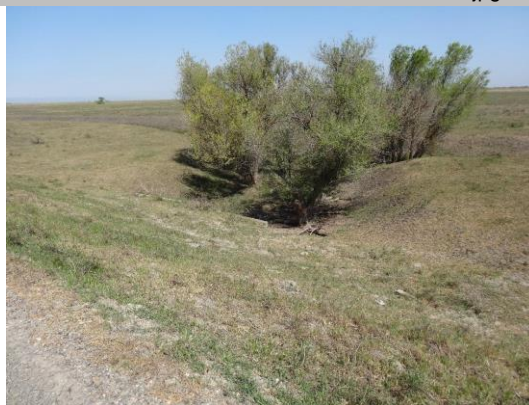
Photo 2 of 3 : UCIP\_SP\_2018\_39523\_62027.jpg

View of landward side.

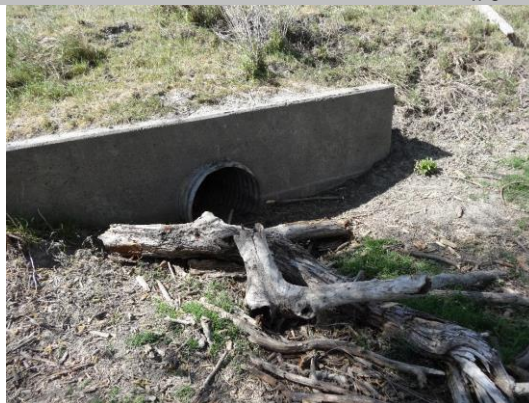
Photo 3 of 3 : UCIP\_SP\_2018\_39523\_62030.jpg

LM Start	3.04	Rating **	M	Issue No.	18 (cont)	
LM End	3.04	Issue Type +	Ma	Location *		
Category	Supplemental			GPS Latitude/Longitude		
				Start		End
Item	DWR UCIP LMA Responsibility			37.202494 °		37.202494 °
				-120.700153 °		-120.700153 °
DWR ID						
Comment Code						
Inspector Comment						
FS_ID:39523 DS_ID:19852 EP_NO: N/A Repair Type: Non-Urgent Crossing Status: Found UCIP Comments: Need to contact owner. Recommend clearing sediment deposit inside pipe. FIELD_STRUCT_DESC: 24-inch corrugated metal gravity drainage pipe through the levee, 15 feet below the crown. Flap gate on the waterside (WS) end. [Additional Reference(s): DWR Levee Log, 2002. USACE San Joaquin O&M Manual 601.1, 1967, (HLM 3.04)]. FS Date: 4/18/2014

Concrete headwall located on landward side--debris in front of headwall.

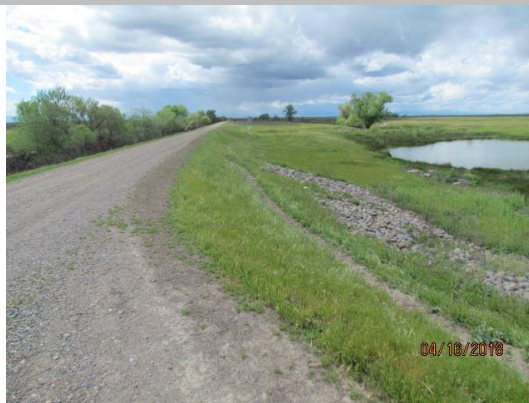
Photo 1 of 1 : SP\_2018\_NA0010\_130\_12\_20180420\_00025.jpg

LM Start	0.00	Rating **	M	Issue No.	12
LM End	3.33	Issue Type +	Ma	Location *	WS
Category	Earthen Levee			GPS Latitude/Longitude	
				Start	End
Item	Vegetation			37.200959 °	37.200979 °
				-120.755286 °	-120.694899 °
DWR ID	DWR_NA0010_12_s_2018_12				
Comment Code					
V1 : Control annual grass and weeds on the levee slopes and easements.					
Inspector Comment

Looking south at typical view of waterward slope. (Spring 2018)

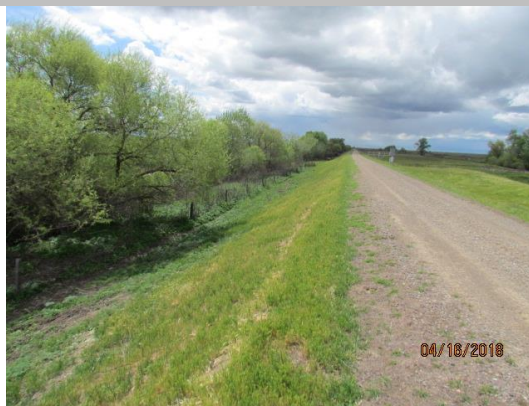
Photo 1 of 1 : SP\_2018\_NA0010\_130\_11\_20180420\_00026.jpg

LM Start	0.00	Rating **	M	Issue No.	11
LM End	3.33	Issue Type +	Ma	Location *	LS
Category	Earthen Levee			GPS Latitude/Longitude	
				Start	End
Item	Vegetation			37.200959 °	37.200981 °
				-120.755286 °	-120.694899 °
DWR ID	DWR_NA0010_12_s_2018_11				
Comment Code					
V1 : Control annual grass and weeds on the levee slopes and easements.					
Inspector Comment

Looking south at typical view of landward slope. (Spring 2018)

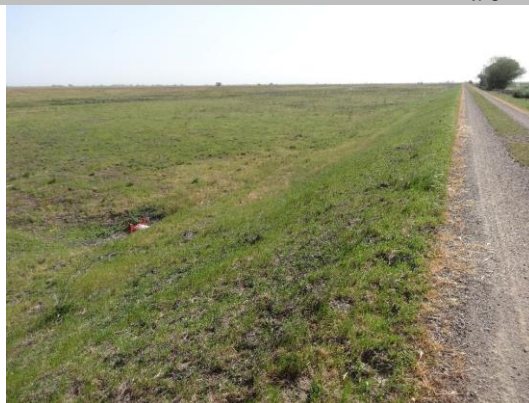
Photo 1 of 3 : UCIP\_SP\_2018\_39889\_62048.jpg

LM Start	1.06	Rating **	M	Issue No.	15
LM End	1.06	Issue Type +	Ma	Location *	
Category	Supplemental			GPS Latitude/Longitude	
				Start	End
Item	DWR UCIP LMA Responsibility			37.200922 °	37.200922 °
				-120.736012 °	-120.736012 °
DWR ID					
Comment Code					
Inspector Comment					
FS_ID:39889					
DS_ID:19856					
EP_NO: N/A					
Repair Type: Non-Urgent					
Crossing Status: Found					
UCIP Comments: Need to contact owner. Recommend clearing sediment deposit inside pipe.					
FIELD_STRUCT_DESC: 24-inch corrugated metal gravity drainage pipe through the levee, 10.5 feet below the crown. Flap gate on the waterside (WS) end. [Additional Reference(s): DWR Levee Log, 2002. USACE San Joaquin O&M Manual 601.1, 1967, (HLM 1.06)].					
FS Date: 4/18/2014

View of waterward side.

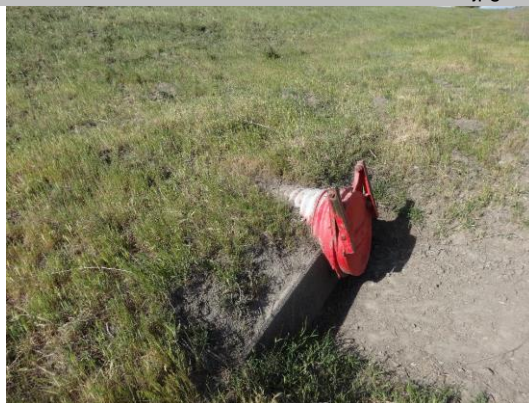
Photo 2 of 3 : UCIP\_SP\_2018\_39889\_62049.jpg

Concrete headwall and flap gate visible on waterward side.

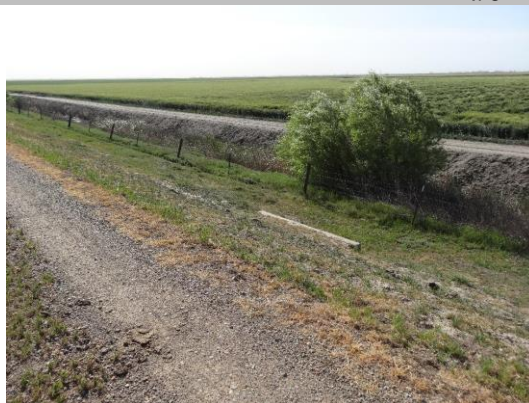
Photo 3 of 3 : UCIP\_SP\_2018\_39889\_62047.jpg

LM Start	1.06	Rating **	M	Issue No.	15 (cont)	
LM End	1.06	Issue Type +	Ma	Location *		
Category	Supplemental			GPS Latitude/Longitude		
				Start		End
Item	DWR UCIP LMA Responsibility			37.200922 °	37.200922 °	
				-120.736012 °	-120.736012 °	
DWR ID						
Comment Code						
Inspector Comment						
FS_ID:39889						
DS_ID:19856						
EP_NO: N/A						
Repair Type: Non-Urgent						
Crossing Status: Found						
UCIP Comments: Need to contact owner. Recommend clearing						
sediment deposit inside pipe.						
FIELD_STRUCT_DESC: 24-inch corrugated metal gravity drainage pipe						
through the levee, 10.5 feet below the crown. Flap gate on the						
waterside (WS) end. [Additional Reference(s): DWR Levee Log, 2002.						
USACE San Joaquin O&M Manual 601.1, 1967, (HLM 1.06)].						
FS Date: 4/18/2014

View of landward side.

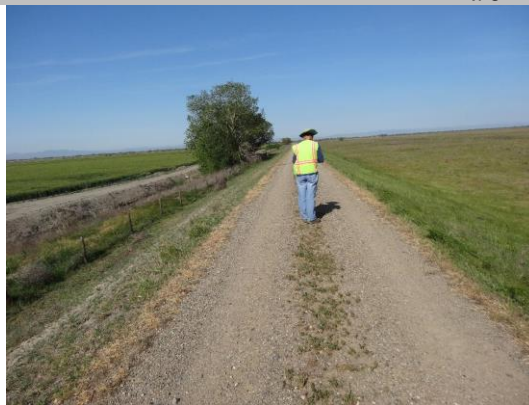
Photo 1 of 3 : UCIP\_SP\_2018\_36705\_66654.jpg

LM Start	1.27	Rating **	M	Issue No.	16
LM End	1.27	Issue Type +	Ma	Location *	
Category	Supplemental			GPS Latitude/Longitude	
				Start	End
Item	DWR UCIP LMA Responsibility			37.200919 °	37.200919 °
				-120.732234 °	-120.732234 °
DWR ID

Comment Code					
Inspector Comment					
FS_ID:36705 DS_ID:19857 EP_NO: N/A Repair Type: Non-Urgent Crossing Status: Found UCIP Comments: Landward side not accessible due to dense vegetation and fence. Concrete headwall and flap gate under water therefore not able to evaluate condition. Will need to coordinate with owner to evaluate condition of crossing on waterward side and obtain access to evaluate landward side. FIELD_STRUCT_DESC: 24-inch corrugated metal gravity drainage pipe through the levee, 17.4 feet below the crown. Flap gate on the waterside (WS) end. [Additional Reference(s): DWR Levee Log, 2002. USACE San Joaquin O&M Manual 601.1, 1967, (HLM 1.27)]. FS Date: 4/18/2014

Overview of levee crown at crossing.

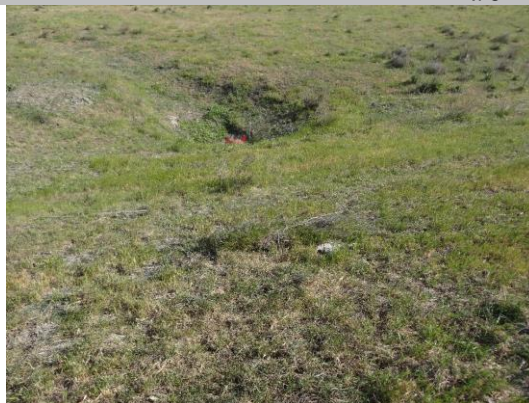
Photo 1 of 3 : UCIP\_SP\_2018\_34126\_62060.jpg

LM Start	1.53	Rating **	M	Issue No.	17
LM End	1.53	Issue Type +	Ma	Location *	
Category	Supplemental			GPS Latitude/Longitude	
				Start	End
Item	DWR UCIP LMA Responsibility			37.200913 °	37.200913 °
				-120.727496 °	-120.727496 °
DWR ID					
Comment Code					
Inspector Comment					
FS_ID:34126 DS_ID:19858 EP_NO: N/A Repair Type: Non-Urgent Crossing Status: Found UCIP Comments: Limited access on landward side due to fence and dense vegetation. Recommend obtaining access to landward side and clear vegetation on landward side. FIELD_STRUCT_DESC: 24-inch corrugated metal gravity drainage pipe through the levee, 10.7 feet below the crown. Flap gate on the waterside (WS) end. [Additional Reference(s): DWR Levee Log, 2002. USACE San Joaquin O&M Manual 601.1, 1967, (HLM 1.53)]. FS Date: 4/18/2014

View of waterward side.

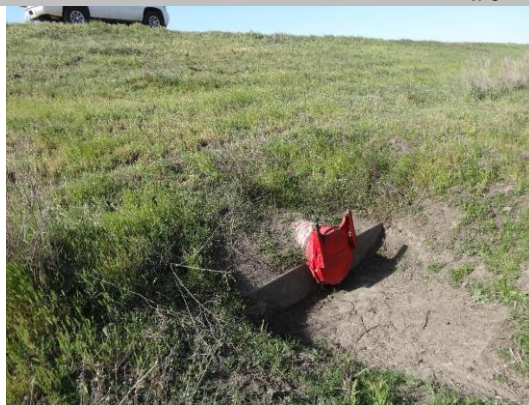
Photo 2 of 3 : UCIP\_SP\_2018\_34126\_62061.jpg

Concrete headwall and flap gate visible on waterward side.

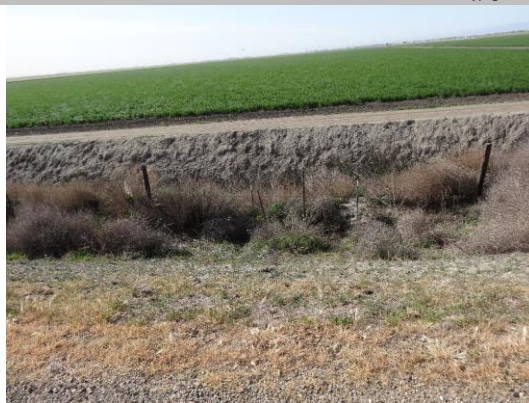
Photo 3 of 3 : UCIP\_SP\_2018\_34126\_62059.jpg

LM Start	1.53	Rating **	M	Issue No.	17 (cont)	
LM End	1.53	Issue Type +	Ma	Location *		
Category	Supplemental			GPS Latitude/Longitude		
				Start	End	
Item	DWR UCIP LMA Responsibility			37.200913 °	37.200913 °	
				-120.727496 °	-120.727496 °	
DWR ID						
Comment Code						
Inspector Comment						
FS_ID:34126 DS_ID:19858 EP_NO: N/A Repair Type: Non-Urgent Crossing Status: Found UCIP Comments: Limited access on landward side due to fence and dense vegetation. Recommend obtaining access to landward side and clear vegetation on landward side. FIELD_STRUCT_DESC: 24-inch corrugated metal gravity drainage pipe through the levee, 10.7 feet below the crown. Flap gate on the waterside (WS) end. [Additional Reference(s): DWR Levee Log, 2002. USACE San Joaquin O&M Manual 601.1, 1967, (HLM 1.53)]. FS Date: 4/18/2014

View of landward side--limited access due to fence.

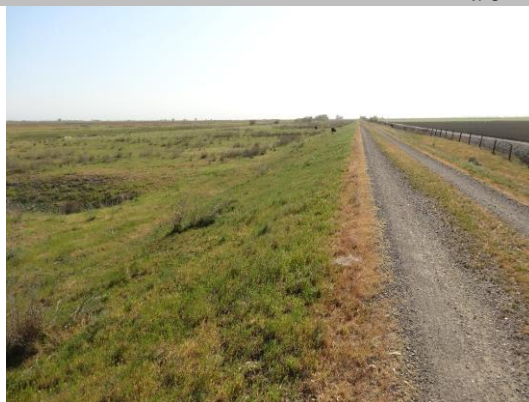
Photo 1 of 3 : UCIP\_SP\_2018\_39506\_62064.jpg

LM Start	2.16	Rating **	M	Issue No.	18
LM End	2.16	Issue Type +	Ma	Location *	
Category	Supplemental			GPS Latitude/Longitude	
				Start	End
Item	DWR UCIP LMA Responsibility			37.200908 °	37.200908 °
				-120.716118 °	-120.716118 °
DWR ID					
Comment Code					
Inspector Comment					
FS_ID:39506					
DS_ID:19859					
EP_NO: N/A					
Repair Type: Non-Urgent					
Crossing Status: Found					
UCIP Comments: Need to contact owner. Recommend clearing vegetation from landward side--headwall blocked.					
FIELD_STRUCT_DESC: 24-inch corrugated metal gravity drainage pipe through the levee, 14.4 feet below the crown. Flap gate on the waterside (WS) end. [Additional Reference(s): DWR Levee Log, 2002. USACE San Joaquin O&M Manual 601.1, 1967, (HLM 2.16)].					
FS Date: 4/18/2014

View of waterward side.

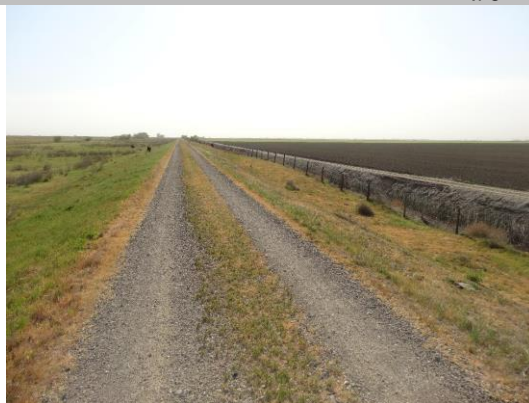
Photo 2 of 3 : UCIP\_SP\_2018\_39506\_62063.jpg

LM Start	2.16	Rating **	M	Issue No.	18 (cont)	
LM End	2.16	Issue Type +	Ma	Location *		
Category	Supplemental			GPS Latitude/Longitude		
				Start	End	
Item	DWR UCIP LMA Responsibility			37.200908 °	37.200908 °	
				-120.716118 °	-120.716118 °	
DWR ID						
Comment Code						
Inspector Comment						
FS_ID:39506						
DS_ID:19859						
EP_NO: N/A						
Repair Type: Non-Urgent						
Crossing Status: Found						
UCIP Comments: Need to contact owner. Recommend clearing vegetation from landward side--headwall blocked.						
FIELD_STRUCT_DESC: 24-inch corrugated metal gravity drainage pipe through the levee, 14.4 feet below the crown. Flap gate on the waterside (WS) end. [Additional Reference(s): DWR Levee Log, 2002. USACE San Joaquin O&M Manual 601.1, 1967, (HLM 2.16)].						
FS Date: 4/18/2014

Overview of levee crown at crossing.

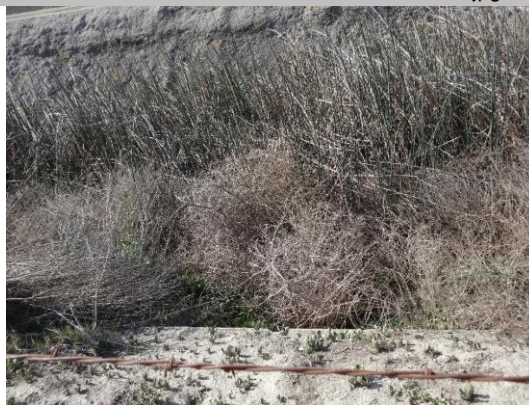
Photo 3 of 3 : UCIP\_SP\_2018\_39506\_62062.jpg

Dense vegetation on landward side--limited access due to fence along landward side.

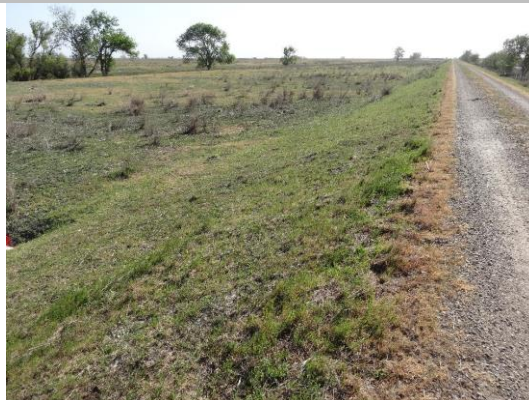
Photo 1 of 3 : UCIP SP 2018 39890 62069.jpg

View of waterward side.

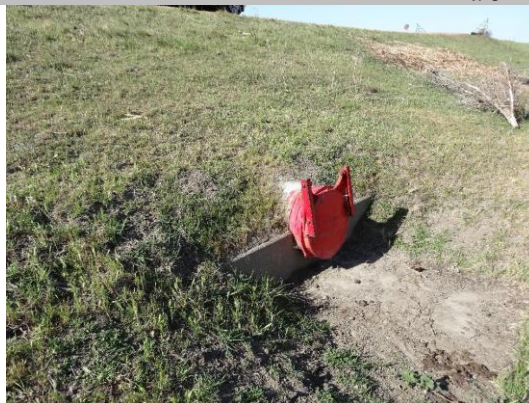
Photo 2 of 3 : UCIP\_SP\_2018\_39890\_62070.jpg

LM Start	2.70	Rating **	M	Issue No.	19 (cont)	
LM End	2.70	Issue Type +	Ma	Location *		
Category	Supplemental			GPS Latitude/Longitude		
				Start	End	
Item	DWR UCIP LMA Responsibility			37.200906 °	37.200906 °	
				-120.706316 °	-120.706316 °	
DWR ID						
Comment Code						
Inspector Comment						
FS_ID:39890						
DS_ID:19860						
EP_NO: N/A						
Repair Type: Non-Urgent						
Crossing Status: Found						
UCIP Comments: Need to contact owner. Recommend clearing						
sediment deposit inside pipe.						
FIELD_STRUCT_DESC: 24-inch corrugated metal gravity drainage pipe						
through the levee, 10.7 feet below the crown. Flap gate on the						
waterside (WS) end. [Additional Reference(s): DWR Levee Log, 2002.						
USACE San Joaquin O&M Manual 601.1, 1967, (HLM 2.70)].						
FS Date: 4/18/2014

Concrete headwall and flat gate located on waterward side.

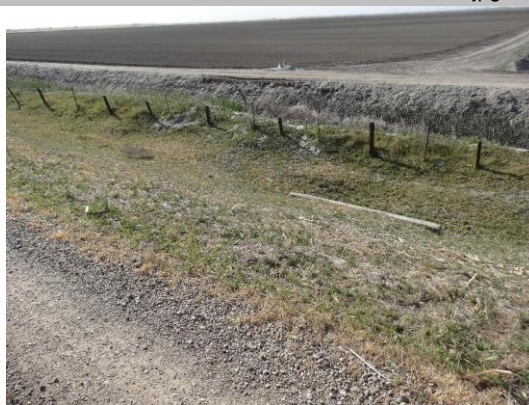
Photo 3 of 3 : UCIP\_SP\_2018\_39890\_62068.jpg

View of landward side.

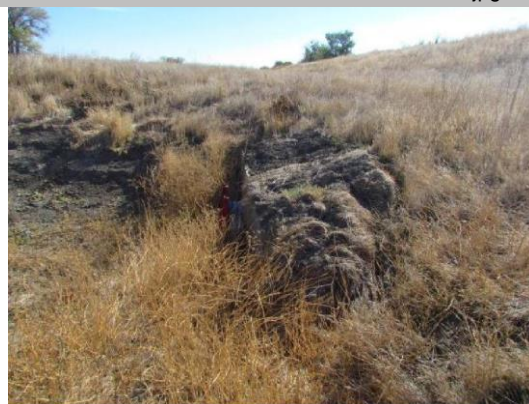
Photo 2 of 3 : UCIP\_SP\_2018\_46786\_74729.jpg

Repair to headwall located on waterward side has been addressed.

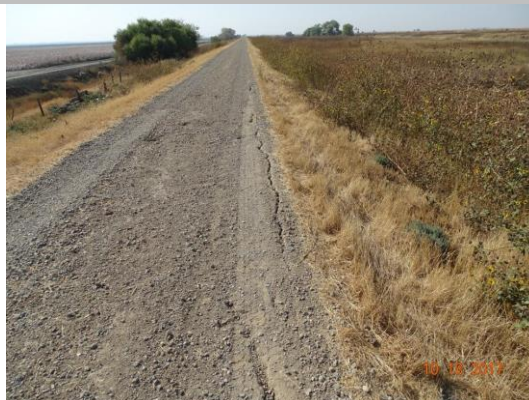
Photo 1 of 3 : SP\_2018\_NA0010\_130\_10\_20180307\_00001.jpg

LM Start	3.00	Rating **	M	Issue No.	10
LM End	3.02	Issue Type +	Ma	Location *	CR
Category	Earthen Levee			GPS Latitude/Longitude	
				Start	End
Item	Cracking			37.200912 °	37.200916 °
				-120.700797 °	-120.700536 °
DWR ID	DWR_NA0010_12_f_2017_10				
Comment Code					
CR1 : Monitor and have inspected by geotechnical engineer.					
Inspector Comment					
Cracking on crown near shoulder approximately 75 feet long should be monitored.

Looking west at the waterside shoulder.

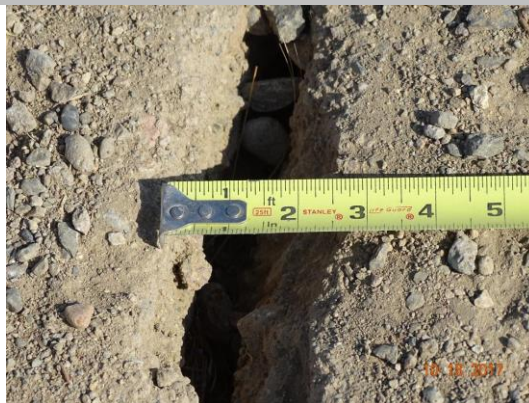
Photo 2 of 3 : SP\_2018\_NA0010\_130\_10\_20180307\_00002.jpg

LM Start	3.00	Rating **	M	Issue No.	10 (cont)	
LM End	3.02	Issue Type +	Ma	Location *	CR	
Category	Earthen Levee			GPS Latitude/Longitude		
				Start		End
Item	Cracking			37.200912 °		37.200916 °
				-120.700797 °		-120.700536 °
DWR ID	DWR_NA0010_12_f_2017_10					
Comment Code						
CR1 : Monitor and have inspected by geotechnical engineer.						
Inspector Comment						
Cracking on crown near shoulder approximately 75 feet long should be monitored.

Typical measurement of the cracking on crown shoulder.

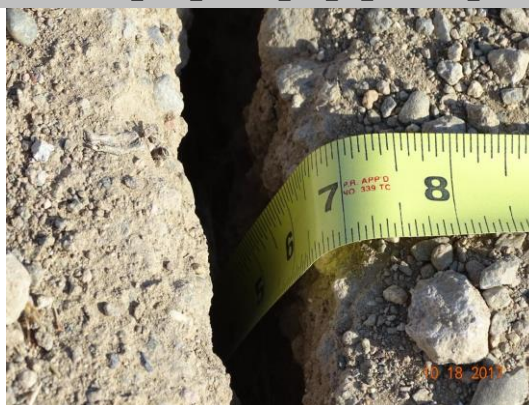
Photo 3 of 3 : SP\_2018\_NA0010\_130\_10\_20180307\_00003.jpg

Typical depth of the cracking on crown shoulder.

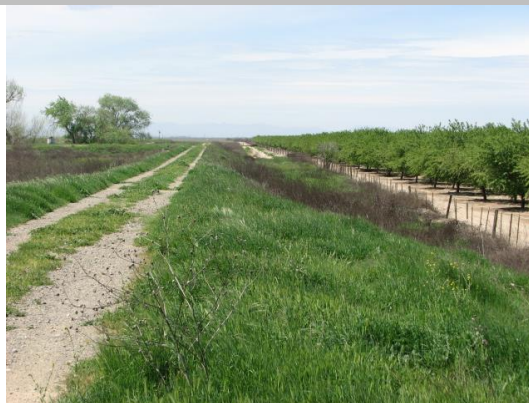
Photo 1 of 1 : SP\_2018\_NA0010\_131\_8\_20180411\_00017.jpg

LM Start	0.00	Rating **	M	Issue No.	8
LM End	1.26	Issue Type +	Ma	Location *	LS
Category	Earthen Levee			GPS Latitude/Longitude	
				Start	End
Item	Vegetation			37.033765 °	37.046311 °
				-120.442120 °	-120.428114 °
DWR ID	DWR_NA0010_13_s_2018_8				
Comment Code					
V1 : Control annual grass and weeds on the levee slopes and easements.					
Inspector Comment

Looking upstream at typical view of landward slope. (Spring 2018)

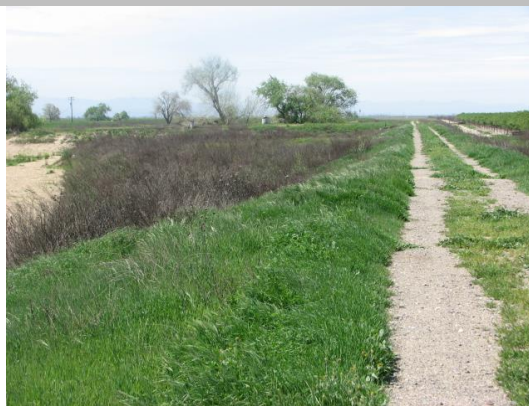
Photo 1 of 1 : SP\_2018\_NA0010\_131\_9\_20180411\_00018.jpg

LM Start	0.00	Rating **	M	Issue No.	9
LM End	1.26	Issue Type +	Ma	Location *	WS
Category	Earthen Levee			GPS Latitude/Longitude	
				Start	End
Item	Vegetation			37.033767 °	37.046311 °
				-120.442121 °	-120.428114 °
DWR ID	DWR_NA0010_13_s_2018_9				
Comment Code					
V1 : Control annual grass and weeds on the levee slopes and easements.					
Inspector Comment

Looking upstream at typical view of waterward slope. (Spring 2018)

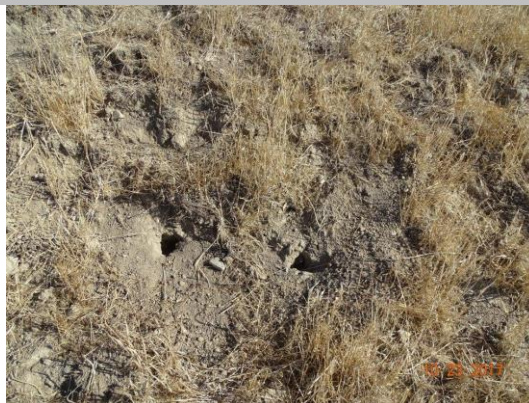
Photo 1 of 1 : SP\_2018\_NA0010\_131\_3\_20180307\_00001.jpg

LM Start	0.15	Rating **	M	Issue No.	3
LM End	0.15	Issue Type +	Ma	Location *	LS
Category	Earthen Levee			GPS Latitude/Longitude	
				Start	End
Item	Animal Control			37.035760 °	37.035760 °
				-120.441282 °	-120.441282 °
DWR ID	DWR_NA0010_13_s_2012_3				
Comment Code					
A3 : No rodents visible, but rodent burrows visible; need to backfill and compact or grout burrows.					
Inspector Comment

Looking at the landside slope.

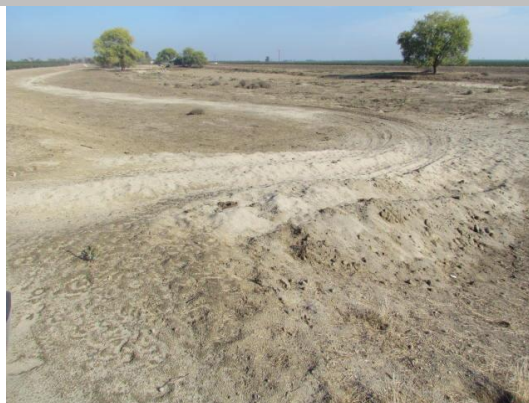
Photo 1 of 3 : SP\_2018\_NA0010\_131\_5\_20180307\_00002.jpg

Looking at unauthorized ramp on waterward slope. (Fall 2014)

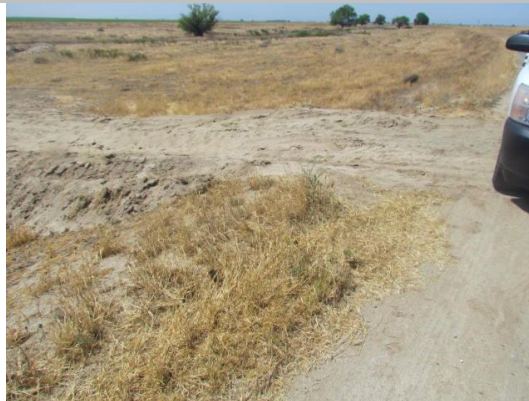
Photo 2 of 3 : SP\_2018\_NA0010\_131\_5\_20180307\_00003.jpg

Looking west at unauthorized ramp on waterward slope.

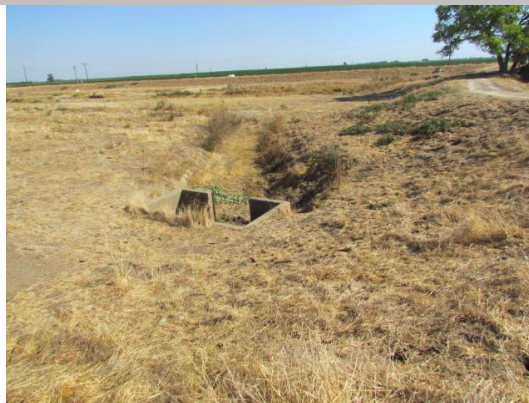
Photo 2 of 6 : SP\_2018\_NA0010\_131\_6\_20180307\_00006.jpg

Looking west at upstream side of sand dam on the southside of the Drop structure.

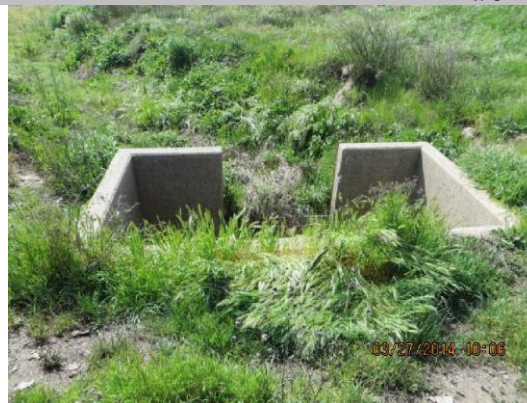
Photo 2 of 3 : UCIP\_SP\_2018\_39877\_59384.jpg

Comment Code						
Inspector Comment						
FS_ID:39877						
DS_ID:19727						
EP_NO: N/A						
Repair Type: Non-Urgent						
Crossing Status: Found						
UCIP Comments: Appears abandoned and if so should be done so properly. Pipe filled with soil on WS at outlet. Actuator missing from slide gate on WS shoulder.						
FIELD_STRUCT_DESC: 1 of 2: 36-inch corrugated metal gravity drainage pipe through the levee, 12.3 feet below the crown. Slide gate in a 48-inch corrugated metal pipe (CMP) riser on the waterside (WS) slope. 6-foot by 12-foot concrete distribution box on the landside (LS). 7-foot by 14-foot concrete outlet structure on the WS toe. [Additional Reference(s): DWR Levee Log, 2002. USACE San Joaquin O&M Manual 601.1, 1967, (HLM 1.14)].						
FS Date: 3/27/2014

Concrete box on WS toe.

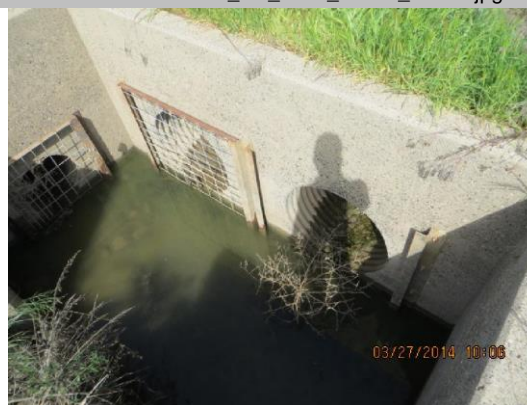
Photo 3 of 3 : UCIP\_SP\_2018\_39877\_59389.jpg

Concrete box on WS toe.

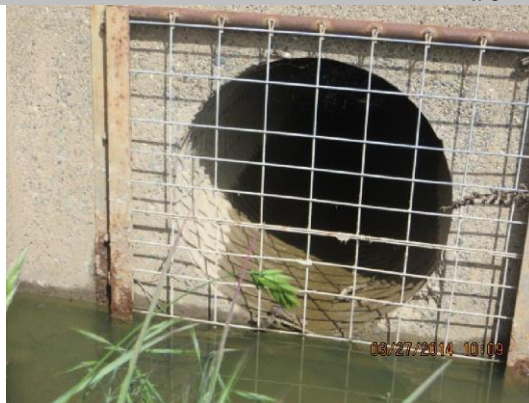
Photo 3 of 3 : UCIP\_SP\_2018\_39524\_59391.jpg

Comment Code						
Inspector Comment						
FS_ID:39524 DS_ID:19908 EP_NO: N/A Repair Type: Non-Urgent Crossing Status: Found UCIP Comments: No lid on riser at WS shoulder could be safety issue. FIELD_STRUCT_DESC: 2 of 2: 36-inch corrugated metal gravity drainage pipe through the levee, 12.3 feet below the crown. Slide gate in a 48-inch corrugated metal pipe (CMP) riser on the waterside (WS) slope. 6-foot by 12-foot concrete distribution box on the landside (LS). 7-foot by 14-foot concrete outlet structure on the WS toe. [Additional Reference(s): DWR Levee Log, 2002. USACE San Joaquin O&M Manual 601.1, 1967, (HLM 1.14)]. FS Date: 3/27/2014

Pipe at outlet on WS toe.
