**Flood Control Project Maintenance  
Levee Inspections**  
**LMA District Cover Sheet**  
**Spring 2018 Levee Inspection Results**

**Lower San Joaquin Levee District**

**Spring 2018 Levee Inspection Results**

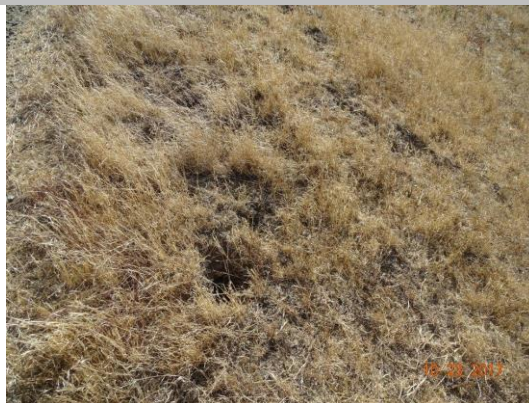
Photo 1 of 1 : SP\_2018\_NA0010\_132\_5\_20180307\_00002.jpg

LM Start	0.25	Rating **	M	Issue No.	5
LM End	0.25	Issue Type +	Ma	Location *	LS
Category	Earthen Levee			GPS Latitude/Longitude	
				Start	End
Item	Animal Control			37.035841 °	37.035841 °
				-120.439795 °	-120.439795 °
DWR ID	DWR_NA0010_14_f_2017_5				
Comment Code					
A3 : No rodents visible, but rodent burrows visible; need to backfill and compact or grout burrows.					
Inspector Comment

Looking at the landside slope.

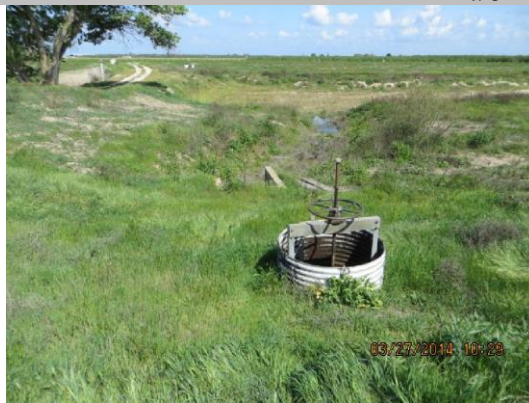
Photo 1 of 3 : UCIP\_SP\_2018\_39526\_59398.jpg

Comment Code						
Inspector Comment						
FS_ID:39526 DS_ID:19909 EP_NO: N/A Repair Type: Non-Urgent Crossing Status: Found UCIP Comments: Lid should be installed on CMP riser on WS slope, could be a safety hazard. Also dense vegetation limits the inspector's visibility to identify signs of pipe failure (leaks) along the slope. Recommend removing vegetation along pipe alignment to conduct proper inspection of structure. FIELD_STRUCT_DESC: 36-inch corrugated metal gravity irrigation pipe through the levee, 10 feet below the crown. Slide gate in a 48-inch corrugated metal pipe (CMP) riser on the waterside (WS) slope. 6-foot by 7-foot concrete distribution box at the WS toe. Slots for wooden flashboards on the WS of the box. 7-foot by 9-foot concrete distribution box on the landside (LS), 20 feet from the toe. [Additional Reference(s): DWR Levee Log, 2002. USACE San Joaquin O&M Manual 601.1, 1967, (HLM 1.15)]. FS Date: 3/27/2014

Slide gate in CMP riser and outlet/inlet structure visible in background at WS toe.

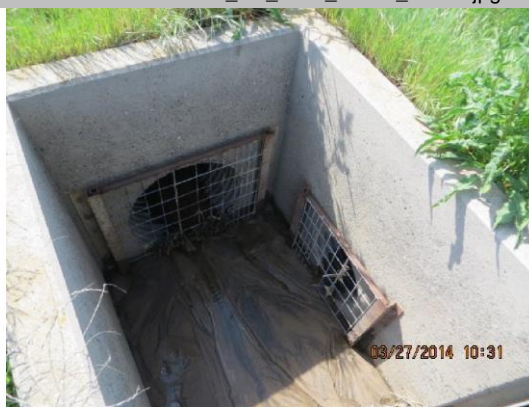
Photo 2 of 3 : UCIP\_SP\_2018\_39526\_59396.jpg

concrete inlet/outlet at WS toe.

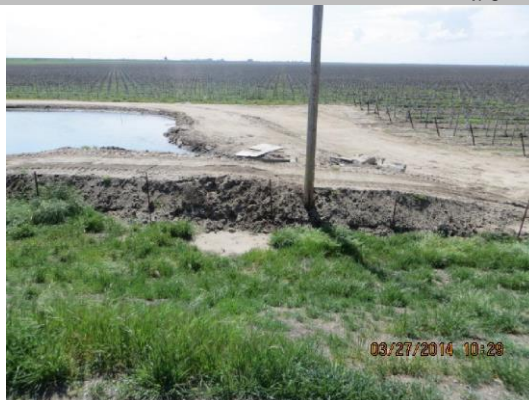
Photo 3 of 3 : UCIP\_SP\_2018\_39526\_59397.jpg

Comment Code						
Inspector Comment						
FS_ID:39526 DS_ID:19909 EP_NO: N/A Repair Type: Non-Urgent Crossing Status: Found UCIP Comments: Lid should be installed on CMP riser on WS slope, could be a safety hazard. Also dense vegetation limits the inspector's visibility to identify signs of pipe failure (leaks) along the slope. Recommend removing vegetation along pipe alignment to conduct proper inspection of structure. FIELD_STRUCT_DESC: 36-inch corrugated metal gravity irrigation pipe through the levee, 10 feet below the crown. Slide gate in a 48-inch corrugated metal pipe (CMP) riser on the waterside (WS) slope. 6-foot by 7-foot concrete distribution box at the WS toe. Slots for wooden flashboards on the WS of the box. 7-foot by 9-foot concrete distribution box on the landside (LS), 20 feet from the toe. [Additional Reference(s): DWR Levee Log, 2002. USACE San Joaquin O&M Manual 601.1, 1967, (HLM 1.15)]. FS Date: 3/27/2014

Concrete distribution box visible next to power pole off LS toe.

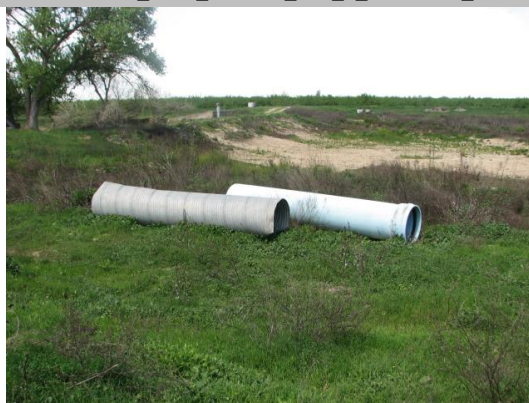
Photo 1 of 1 : SP\_2018\_NA0010\_132\_7\_20180411\_00010.jpg

LM Start	1.16	Rating **	M	Issue No.	7
LM End	1.16	Issue Type +	En	Location *	WS
Category	Earthen Levee			GPS Latitude/Longitude	
				Start	End
Item	Encroachments			37.044987 °	37.044987 °
				-120.429476 °	-120.429476 °
DWR ID	DWR_NA0010_14_s_2018_7				
Comment Code					
PI : Pipe					
Inspector Comment					
Remove pipes stored at waterwater berm.

Looking west at pipes on waterward slope. (Spring 2018)

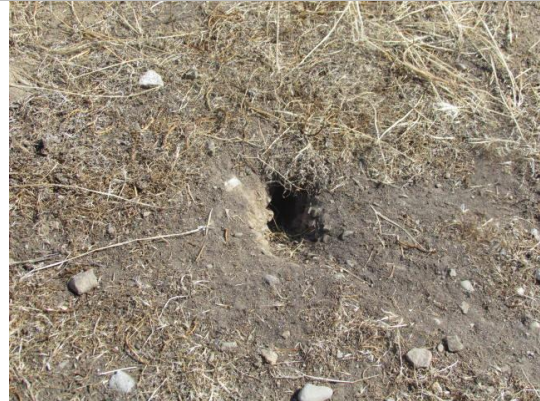
Photo 1 of 1 : SP\_2018\_NA0010\_132\_79\_20180307\_00003.jpg

LM Start	1.24	Rating **	M	Issue No.	79
LM End	1.24	Issue Type +	Ma	Location *	LS
Category	Earthen Levee			GPS Latitude/Longitude	
				Start	End
Item	Animal Control			37.045343 °	37.045343 °
				-120.428007 °	-120.428007 °
DWR ID	DWR_NA0010_14_s_2015_79				
Comment Code					
A3 : No rodents visible, but rodent burrows visible; need to backfill and compact or grout burrows.					
Inspector Comment					
Noted several rodent holes on landside at this location.

Looking at typical view of rodent holes on landward slope.

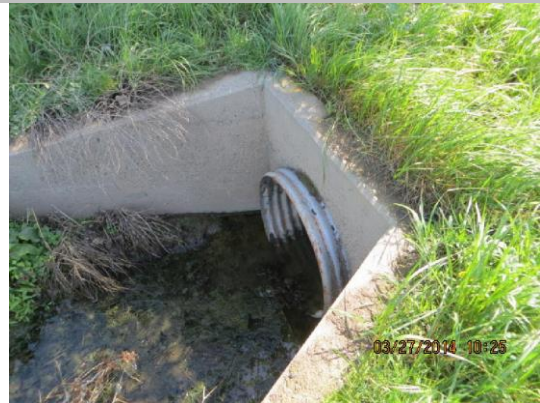
Photo 1 of 3 : UCIP\_SP\_2018\_32828\_59402.jpg

LM Start	1.26	Rating **	A/W	Issue No.	81
LM End	1.26	Issue Type +	Ma	Location *	
Category	Supplemental			GPS Latitude/Longitude	
				Start	End
Item	DWR UCIP LMA Responsibility			37.045383 °	37.045383 °
				-120.427754 °	-120.427754 °
DWR ID					
Comment Code					
Inspector Comment					
FS_ID:32828 DS_ID:19910 EP_NO: N/A Repair Type: No Action Needed Crossing Status: Found UCIP Comments: FIELD_STRUCT_DESC: 36-inch corrugated metal gravity drainage pipe through the levee, 9 feet below the crown. Slide gate in a 42-inch corrugated metal pipe (CMP) riser on the waterside (WS) slope. Concrete U-shaped headwall on the WS end. Pipe terminates into a concrete ditch on the landside (LS). [Additional Reference(s): DWR Levee Log, 2002. USACE San Joaquin O&M Manual 601.1, 1967, (HLM 1.26)]. FS Date: 3/27/2014

Concrete U-shaped headwall on Ws toe.

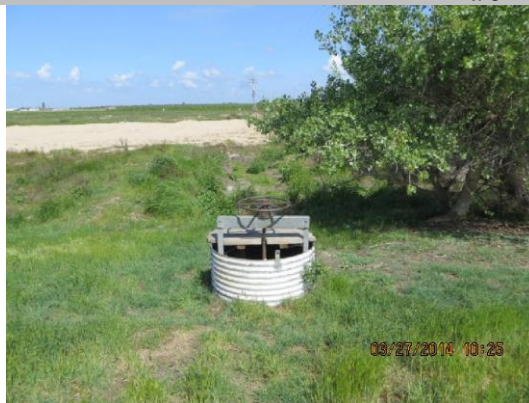
Photo 2 of 3 : UCIP\_SP\_2018\_32828\_59401.jpg

LM Start	1.26	Rating **	A/W	Issue No.	81 (cont)	
LM End	1.26	Issue Type +	Ma	Location *		
Category	Supplemental			GPS Latitude/Longitude		
				Start		End
Item	DWR UCIP LMA Responsibility			37.045383 °		37.045383 °
				-120.427754 °		-120.427754 °
DWR ID						
Comment Code						
Inspector Comment						
FS_ID:32828 DS_ID:19910 EP_NO: N/A Repair Type: No Action Needed Crossing Status: Found UCIP Comments: FIELD_STRUCT_DESC: 36-inch corrugated metal gravity drainage pipe through the levee, 9 feet below the crown. Slide gate in a 42-inch corrugated metal pipe (CMP) riser on the waterside (WS) slope. Concrete U-shaped headwall on the WS end. Pipe terminates into a concrete ditch on the landside (LS). [Additional Reference(s): DWR Levee Log, 2002. USACE San Joaquin O&M Manual 601.1, 1967, (HLM 1.26)]. FS Date: 3/27/2014

slidegate in CMP riser on WS slope.

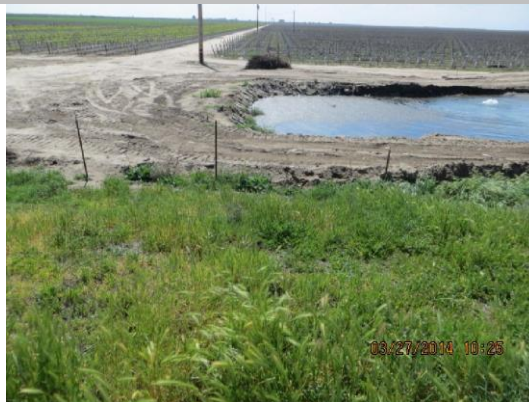
Photo 3 of 3 : UCIP\_SP\_2018\_32828\_59400.jpg

Inlet assumed to be within irrigation structure off LS toe.

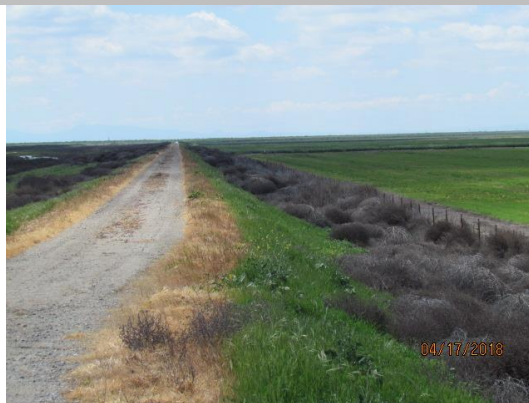
Photo 1 of 1 : SP\_2018\_NA0010\_133\_9\_20180420\_00015.jpg

LM Start	0.00	Rating **	M	Issue No.	9
LM End	2.03	Issue Type +	Ma	Location *	LS
Category	Earthen Levee			GPS Latitude/Longitude	
				Start	End
Item	Vegetation			36.996597 °	36.996599 °
				-120.410440 °	-120.373773 °
DWR ID	DWR_NA0010_15_s_2018_9				
Comment Code					
V1 : Control annual grass and weeds on the levee slopes and easements.					
Inspector Comment

Looking west at typical view of landward slope. (Spring 2018)

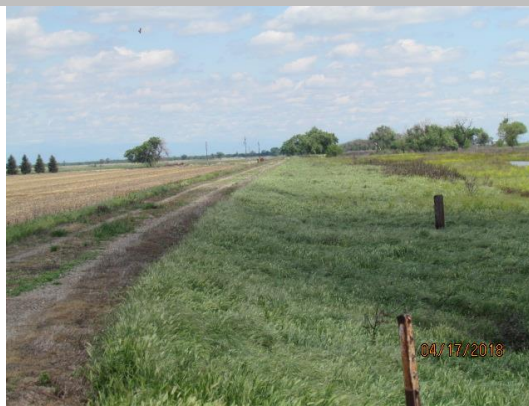
Photo 1 of 1 : SP\_2018\_NA0010\_133\_10\_20180420\_00014.jpg

LM Start	0.00	Rating **	M	Issue No.	10
LM End	2.03	Issue Type +	Ma	Location *	WS
Category	Earthen Levee			GPS Latitude/Longitude	
				Start	End
Item	Vegetation			36.996597 °	36.996599 °
				-120.410440 °	-120.373773 °
DWR ID	DWR_NA0010_15_s_2018_10				
Comment Code					
V1 : Control annual grass and weeds on the levee slopes and easements.					
Inspector Comment

Looking east at typical view of waterward slope. (Spring 2018)

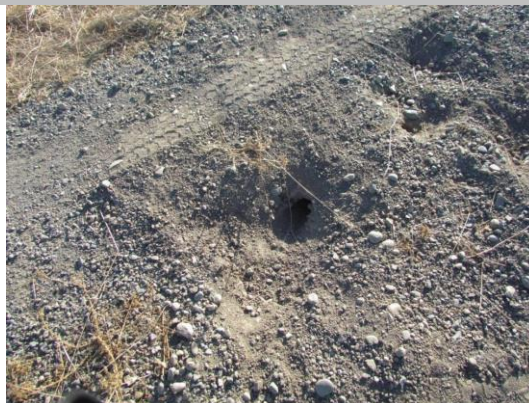
Photo 1 of 1 : SP\_2018\_NA0010\_133\_3\_20180307\_00001.jpg

LM Start	0.37	Rating **	M	Issue No.	3
LM End	0.37	Issue Type +	Ma	Location *	CR
Category	Earthen Levee			GPS Latitude/Longitude	
				Start	End
Item	Animal Control			36.996550 °	36.996550 °
				-120.403647 °	-120.403647 °
DWR ID	DWR_NA0010_15_f_2016_3				
Comment Code					
A3 : No rodents visible, but rodent burrows visible; need to backfill and compact or grout burrows.					
Inspector Comment					
Several rodent holes identified on the levee crown.

Looking at typical rodent holes on levee crown.

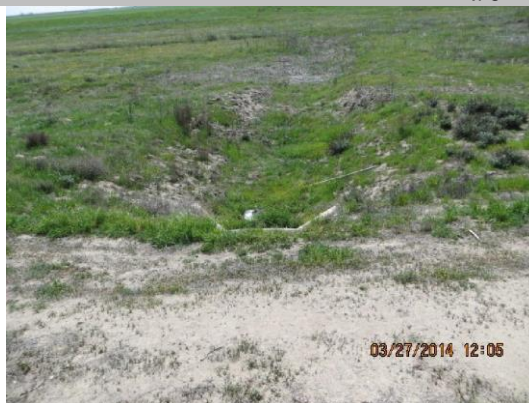
Photo 1 of 3 : UCIP\_SP\_2018\_32838\_59448.jpg

LM Start	0.48	Rating **	A/W	Issue No.	12
LM End	0.48	Issue Type +	Ma	Location *	
Category	Supplemental			GPS Latitude/Longitude	
				Start	End
Item	DWR UCIP LMA Responsibility			36.996551 °	36.996551 °
				-120.401737 °	-120.401737 °
DWR ID					
Comment Code					
Inspector Comment					
FS_ID:32838 DS_ID:19911 EP_NO: N/A Repair Type: No Action Needed Crossing Status: Found UCIP Comments: FIELD_STRUCT_DESC: 30-inch by 30-inch square reinforced concrete box gravity drainage culvert through the levee, 10.1 feet below the crown. Flap gate on the waterside (WS) end. Concrete headwall on the landside (LS) end. Concrete U-shaped headwall on the WS end. [Additional Reference(s): DWR Levee Log, 2002. USACE San Joaquin O&M Manual 601.1, 1967, (HLM 0.48)]. FS Date: 3/27/2014

Concrete headwall on WS toe.

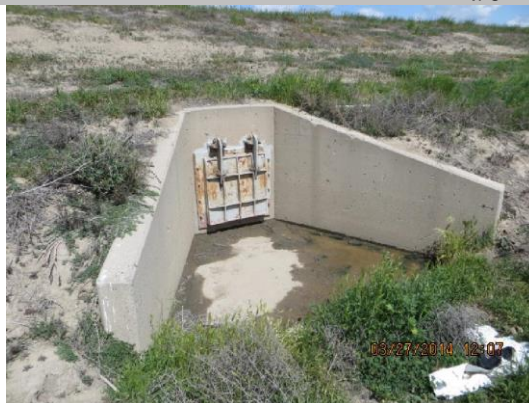
Photo 2 of 3 : UCIP\_SP\_2018\_32838\_59449.jpg

LM Start	0.48	Rating **	A/W	Issue No.	12 (cont)	
LM End	0.48	Issue Type +	Ma	Location *		
Category	Supplemental			GPS Latitude/Longitude		
				Start	End	
Item	DWR UCIP LMA Responsibility			36.996551 °	36.996551 °	
				-120.401737 °	-120.401737 °	
DWR ID						
Comment Code						
Inspector Comment						
FS_ID:32838						
DS_ID:19911						
EP_NO: N/A						
Repair Type: No Action Needed						
Crossing Status: Found						
UCIP Comments:						
FIELD_STRUCT_DESC: 30-inch by 30-inch square reinforced concrete box gravity drainage culvert through the levee, 10.1 feet below the crown. Flap gate on the waterside (WS) end. Concrete headwall on the landside (LS) end. Concrete U-shaped headwall on the WS end.						
[Additional Reference(s): DWR Levee Log, 2002. USACE San Joaquin O&M Manual 601.1, 1967, (HLM 0.48)].						
FS Date: 3/27/2014

Flapgate on Concrete headwall at WS toe.

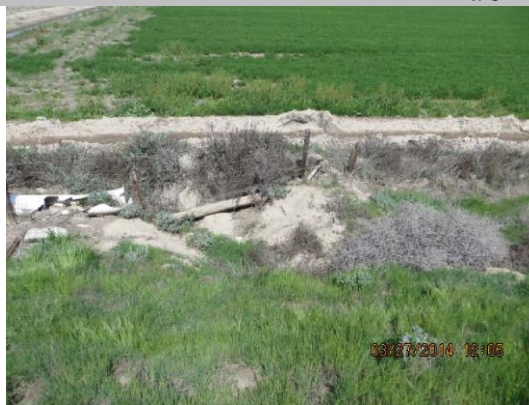
Photo 3 of 3 : UCIP\_SP\_2018\_32838\_59447.jpg

Concrete headwall on LS toe.

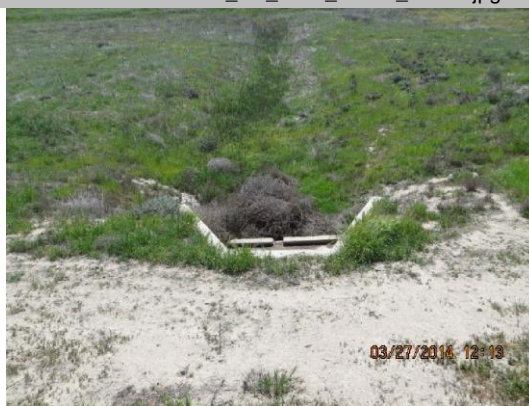
Photo 1 of 3 : UCIP\_SP\_2018\_39527\_59452.jpg

Comment Code					
Inspector Comment					
FS_ID:39527					
DS_ID:19912					
EP_NO: N/A					
Repair Type: Non-Urgent					
Crossing Status: Found					
UCIP Comments: Dense vegetation limits the inspector's visibility to identify signs of pipe failure (leaks) along the landward slope.					
Recommend removing vegetation along pipe alignment to conduct proper inspection of structure.					
FIELD_STRUCT_DESC: 30-inch by 30-inch square reinforced concrete box gravity drainage culvert through the levee, 8.5 feet below the crown.					
Flap gate on the waterside (WS) end. Concrete headwall on the landside (LS) end. Concrete U-shaped headwall on the WS end.					
[Additional Reference(s): DWR Levee Log, 2002. USACE San Joaquin O&M Manual 601.1, 1967, (HLM 1.01)].					
FS Date: 3/27/2014

Concrete headwall on WS toe.

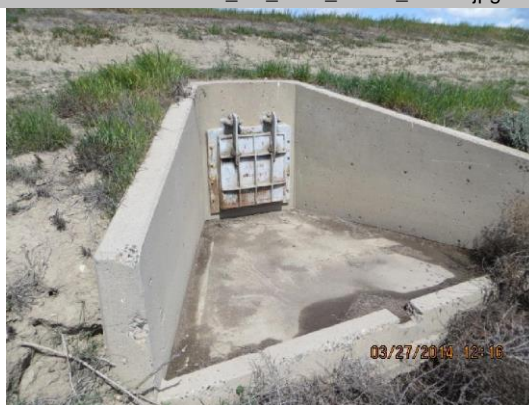
Photo 2 of 3 : UCIP\_SP\_2018\_39527\_59453.jpg

Flapgate on concrete headwall at WS toe.

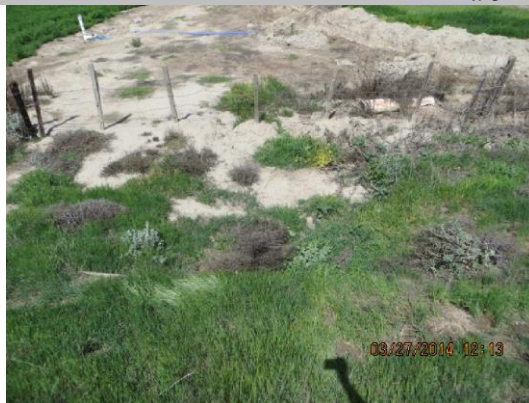
Photo 3 of 3 : UCIP\_SP\_2018\_39527\_59451.jpg

Comment Code						
Inspector Comment						
FS_ID:39527 DS_ID:19912 EP_NO: N/A Repair Type: Non-Urgent Crossing Status: Found UCIP Comments: Dense vegetation limits the inspector's visibility to identify signs of pipe failure (leaks) along the landward slope. Recommend removing vegetation along pipe alignment to conduct proper inspection of structure. FIELD_STRUCT_DESC: 30-inch by 30-inch square reinforced concrete box gravity drainage culvert through the levee, 8.5 feet below the crown. Flap gate on the waterside (WS) end. Concrete headwall on the landside (LS) end. Concrete U-shaped headwall on the WS end. [Additional Reference(s): DWR Levee Log, 2002. USACE San Joaquin O&M Manual 601.1, 1967, (HLM 1.01)]. FS Date: 3/27/2014

Concrete headwall on LS toe.

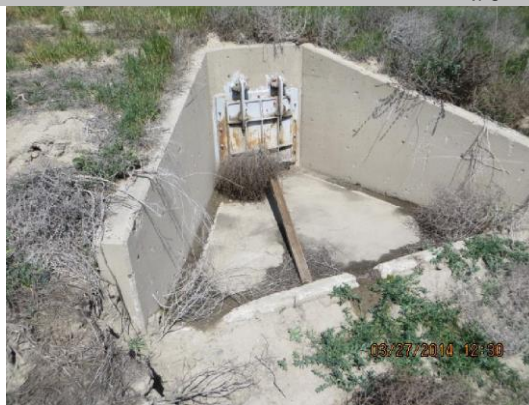
Photo 2 of 3 : UCIP\_SP\_2018\_32840\_59457.jpg

Flapgate on concrete headwall at WS toe.

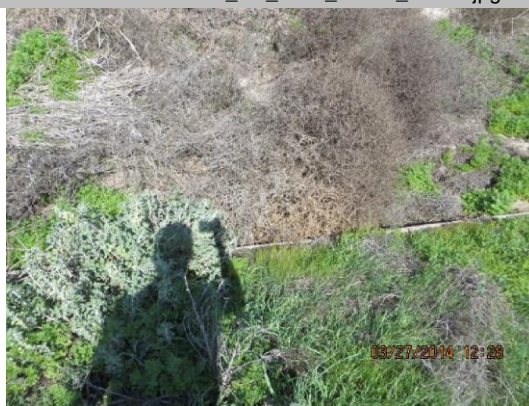
**Lower San Joaquin Levee District**

LM Start	1.53	Rating **	M	Issue No.	14 (cont)	
LM End	1.53	Issue Type +	Ma	Location *		
Category	Supplemental			GPS Latitude/Longitude		
				Start		End
Item	DWR UCIP LMA Responsibility			36.996582 °		36.996582 °
				-120.382757 °		-120.382757 °
DWR ID						
Comment Code						
Inspector Comment						
FS_ID:32840 DS_ID:19913 EP_NO: N/A Repair Type: Non-Urgent Crossing Status: Found UCIP Comments: Excessive vegetation at inlet on LS toe. FIELD_STRUCT_DESC: 30-inch by 30-inch square reinforced concrete box gravity drainage culvert through the levee, 8.9 feet below the crown. Flap gate on the waterside (WS) end. Concrete headwall on the landside (LS) end. Concrete U-shaped headwall on the WS end. [Additional Reference(s): DWR Levee Log, 2002. USACE San Joaquin O&M Manual 601.1, 1967, (HLM 1.53)]. FS Date: 3/27/2014

Concrete headwall on LS toe. Note excessive vegetation buildup.

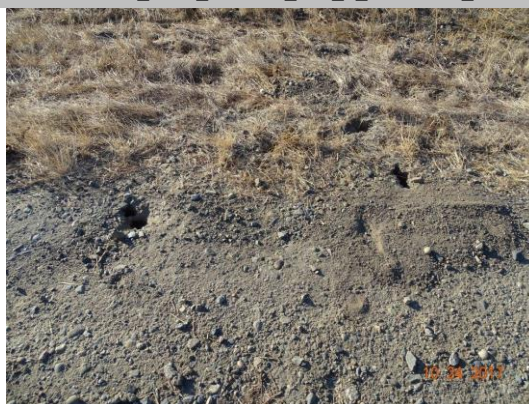
Photo 1 of 1 : SP\_2018\_NA0010\_133\_6\_20180307\_00003.jpg

LM Start	1.58	Rating **	M	Issue No.	6
LM End	2.01	Issue Type +	Ma	Location *	CR
Category	Earthen Levee			GPS Latitude/Longitude	
				Start	End
Item	Animal Control			36.996563 °	36.996578 °
				-120.381895 °	-120.374111 °
DWR ID	DWR_NA0010_15_f_2017_6				
Comment Code					
A3 : No rodents visible, but rodent burrows visible; need to backfill and compact or grout burrows.					
Inspector Comment

Representative picture on the crown.

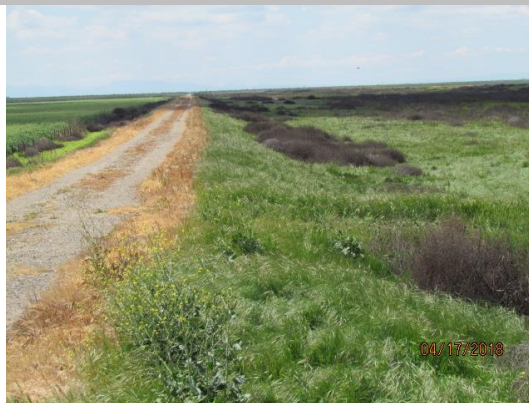
Photo 1 of 1 : SP\_2018\_NA0010\_134\_8\_20180420\_00012.jpg

LM Start	0.00	Rating **	M	Issue No.	8
LM End	1.96	Issue Type +	Ma	Location *	LS
Category	Earthen Levee			GPS Latitude/Longitude	
				Start	End
Item	Vegetation			36.995357 °	36.995497 °
				-120.408923 °	-120.373623 °
DWR ID	DWR_NA0010_16_s_2018_8				
Comment Code					
V1 : Control annual grass and weeds on the levee slopes and easements.					
Inspector Comment

Looking west at typical view of landward slope. (Spring 2018)

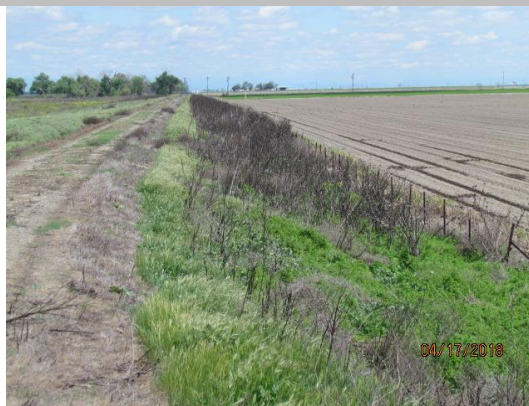
Photo 1 of 1 : SP\_2018\_NA0010\_134\_9\_20180420\_00011.jpg

LM Start	0.00	Rating **	M	Issue No.	9
LM End	1.96	Issue Type +	Ma	Location *	WS
Category	Earthen Levee			GPS Latitude/Longitude	
				Start	End
Item	Vegetation			36.995357 °	36.995497 °
				-120.408923 °	-120.373623 °
DWR ID	DWR_NA0010_16_s_2018_9				
Comment Code					
V1 : Control annual grass and weeds on the levee slopes and easements.					
Inspector Comment

Looking east at typical view of waterward slope. (Spring 2018)

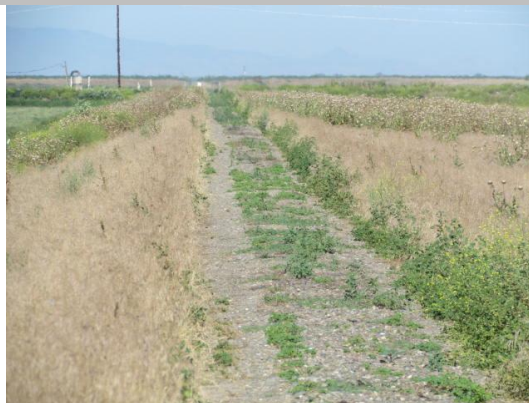
Photo 1 of 1 : SP\_2018\_NA0010\_134\_14\_20180307\_00005.jpg

LM Start	0.01	Rating **	A/W	Issue No.	14
LM End	1.96	Issue Type +	Ma	Location *	CR
Category	Earthen Levee			GPS Latitude/Longitude	
				Start	End
Item	Vegetation			36.995388 °	36.995507 °
				-120.408738 °	-120.373592 °
DWR ID	DWR_NA0010_16_s_2012_14				
Comment Code					
V1 : Control annual grass and weeds on the levee slopes and easements.					
Inspector Comment					
Control vegetation and regrade levee crown.

Looking at typical view of levee crown.

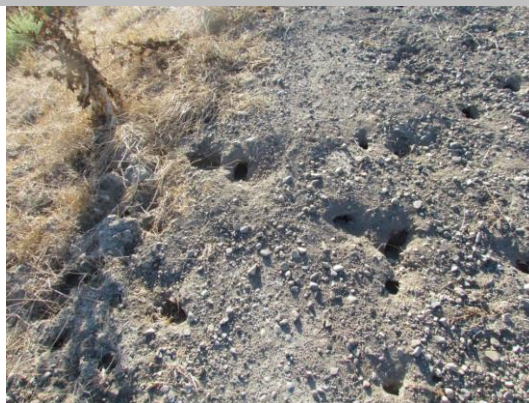
Photo 1 of 1 : SP\_2018\_NA0010\_134\_3\_20180307\_00003.jpg

LM Start	1.09	Rating **	M	Issue No.	3
LM End	1.09	Issue Type +	Ma	Location *	CR
Category	Earthen Levee			GPS Latitude/Longitude	
				Start	End
Item	Animal Control			36.995433 °	36.995433 °
				-120.389190 °	-120.389190 °
DWR ID	DWR_NA0010_16_f_2016_3				
Comment Code					
A3 : No rodents visible, but rodent burrows visible; need to backfill and compact or grout burrows.					
Inspector Comment					
Several rodent holes identified on the levee crown.

Looking at several rodent holes and moles holes on levee crown.

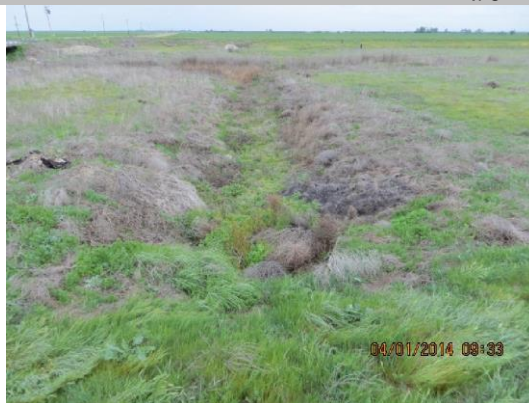
Photo 1 of 3 : UCIP\_SP\_2018\_39529\_59681.jpg

LM Start	1.44	Rating **	M	Issue No.	93
LM End	1.44	Issue Type +	Ma	Location *	
Category	Supplemental			GPS Latitude/Longitude	
				Start	End
Item	DWR UCIP LMA Responsibility			36.995473 °	36.995473 °
				-120.382872 °	-120.382872 °
DWR ID					
Comment Code					
Inspector Comment					
FS_ID:39529 DS_ID:19915 EP_NO: N/A Repair Type: Non-Urgent Crossing Status: Found UCIP Comments: Dense vegetation buildup at landside toe-- recommend clearing. FIELD_STRUCT_DESC: 30-inch by 30-inch square reinforced concrete box gravity drainage culvert through the levee, 8.5 feet below the crown. Two concrete cutoff walls. Flap gate on the waterside (WS) end. Concrete headwall on the landside (LS) end. Concrete U-shaped headwall on the WS end. [Additional Reference(s): DWR Levee Log, 2002. USACE San Joaquin O&M Manual 601.1, 1967, (HLM 1.46)]. FS Date: 4/1/2014 8:12:00 AM

Concrete headwall on WS toe with channel.

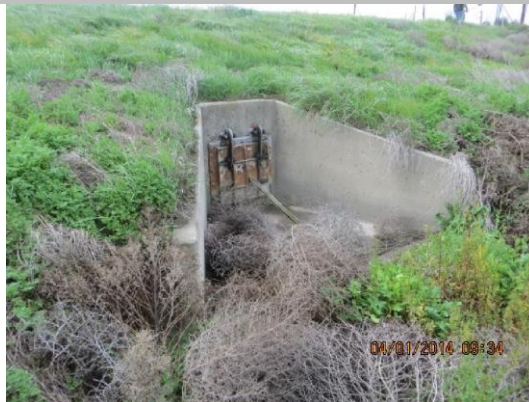
Photo 2 of 3 : UCIP\_SP\_2018\_39529\_59680.jpg

Flapgate on headwall at WS toe.

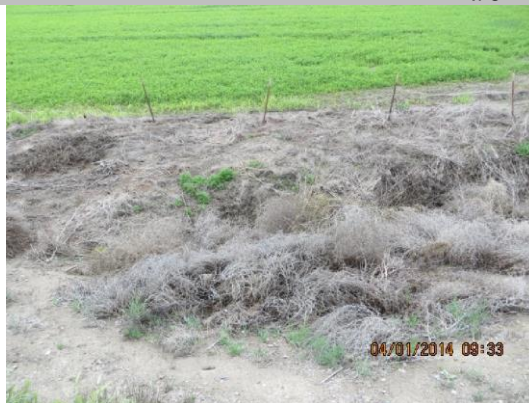
Photo 3 of 3 : UCIP\_SP\_2018\_39529\_59682.jpg

LM Start	1.44	Rating **	M	Issue No.	93 (cont)	
LM End	1.44	Issue Type +	Ma	Location *		
Category	Supplemental			GPS Latitude/Longitude		
				Start		End
Item	DWR UCIP LMA Responsibility			36.995473 °	36.995473 °	
				-120.382872 °	-120.382872 °	
DWR ID						
Comment Code						
Inspector Comment						
FS_ID:39529 DS_ID:19915 EP_NO: N/A Repair Type: Non-Urgent Crossing Status: Found UCIP Comments: Dense vegetation buildup at landside toe-- recommend clearing. FIELD_STRUCT_DESC: 30-inch by 30-inch square reinforced concrete box gravity drainage culvert through the levee, 8.5 feet below the crown. Two concrete cutoff walls. Flap gate on the waterside (WS) end. Concrete headwall on the landside (LS) end. Concrete U-shaped headwall on the WS end. [Additional Reference(s): DWR Levee Log, 2002. USACE San Joaquin O&M Manual 601.1, 1967, (HLM 1.46)]. FS Date: 4/1/2014 8:12:00 AM

Concrete headwall on LS toe covered in vegetation/tumble weeds.

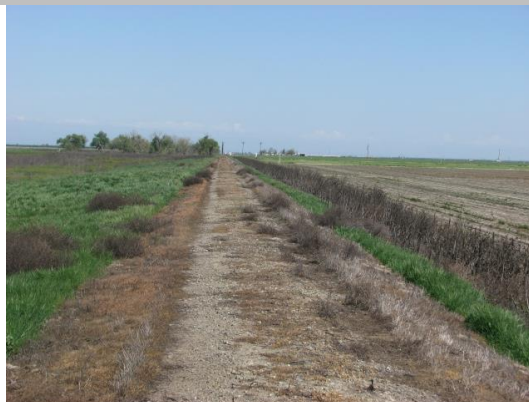
Photo 1 of 1 : SP\_2018\_NA0010\_134\_7\_20180411\_00010.jpg

LM Start	1.46	Rating **	A/W	Issue No.	7
LM End	1.60	Issue Type +	Ma	Location *	CR
Category	Earthen Levee			GPS Latitude/Longitude	
				Start	End
Item	Vegetation			36.995466 °	36.995471 °
				-120.382574 °	-120.380111 °
DWR ID	DWR_NA0010_16_f_2017_7				
Comment Code					
V2 : Remove the wild growth other than native grasses from the levee slopes.					
Inspector Comment

Looking east at typical view of levee crown. (Spring 2018)

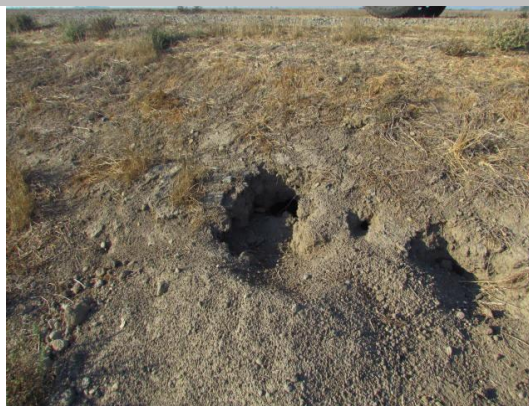
Photo 1 of 2 : SP\_2018\_NA0010\_134\_2\_20180307\_00001.jpg

LM Start	1.77	Rating **	U	Issue No.	2
LM End	1.77	Issue Type +	Ma	Location *	LS
Category	Earthen Levee			GPS Latitude/Longitude	
				Start	End
Item	Animal Control			36.995487 °	36.995487 °
				-120.377054 °	-120.377054 °
DWR ID	DWR_NA0010_16_f_2014_2				
Comment Code					
A3 : No rodents visible, but rodent burrows visible; need to backfill and compact or grout burrows.					
Inspector Comment					
Large rodent holes on landside slope.

Looking at large rodent holes on landward slope.

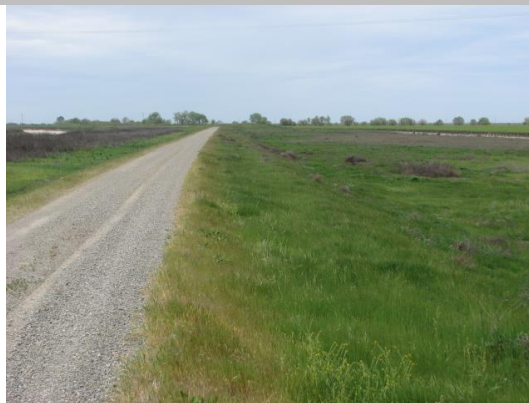
Photo 1 of 1 : SP\_2018\_NA0010\_135\_13\_20180411\_00037.jpg

LM Start	0.00	Rating **	M	Issue No.	13
LM End	16.09	Issue Type +	Ma	Location *	LS
Category	Earthen Levee			GPS Latitude/Longitude	
				Start	End
Item	Vegetation			36.976461 °	36.774440 °
				-120.374672 °	-120.283749 °
DWR ID	DWR_NA0010_17_s_2018_13				
Comment Code					
V1 : Control annual grass and weeds on the levee slopes and easements.					
Inspector Comment

Looking upstream (south) at typical view of landward slope. (Spring 2018)

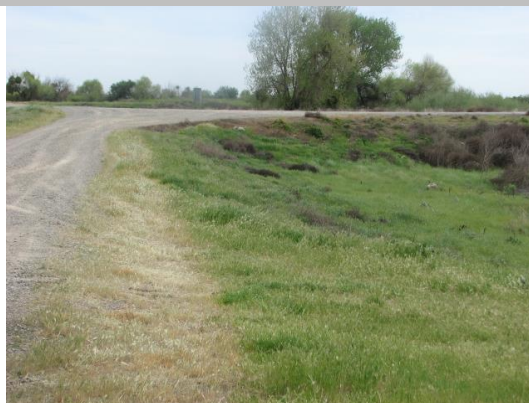
Photo 1 of 1 : SP\_2018\_NA0010\_135\_14\_20180411\_00038.jpg

LM Start	0.00	Rating **	M	Issue No.	14
LM End	16.09	Issue Type +	Ma	Location *	WS
Category	Earthen Levee			GPS Latitude/Longitude	
				Start	End
Item	Vegetation			36.976462 °	36.774440 °
				-120.374672 °	-120.283749 °
DWR ID	DWR_NA0010_17_s_2018_14				
Comment Code					
V1 : Control annual grass and weeds on the levee slopes and easements.					
Inspector Comment

Looking upstream (south) at typical view of waterward slope. (Spring 2018)

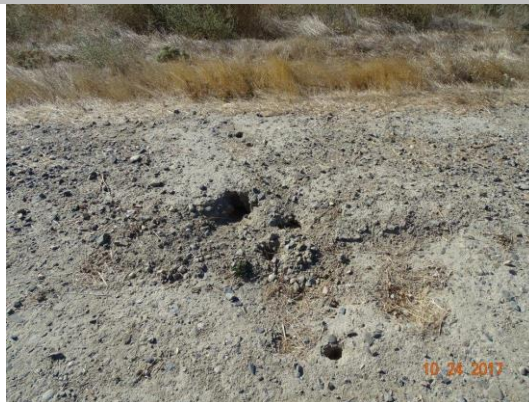
Photo 1 of 1 : SP\_2018\_NA0010\_135\_18\_20180307\_00007.jpg

LM Start	0.64	Rating **	M	Issue No.	18
LM End	0.64	Issue Type +	Ma	Location *	CR
Category	Earthen Levee			GPS Latitude/Longitude	
				Start	End
Item	Animal Control			36.976181 °	36.976181 °
				-120.363241 °	-120.363241 °
DWR ID	DWR_NA0010_17_f_2017_18				
Comment Code					
A3 : No rodents visible, but rodent burrows visible; need to backfill and compact or grout burrows.					
Inspector Comment					
Multiple rodent holes in this area.

Looking at the crown.

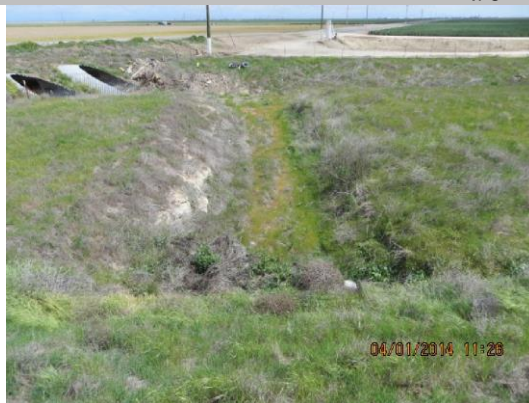
Photo 3 of 3 : UCIP\_SP\_2018\_39531\_59709.jpg

Comment Code						
Inspector Comment						
FS_ID:39531						
DS_ID:19916						
EP_NO: N/A						
Repair Type: Non-Urgent						
Crossing Status: Found						
UCIP Comments: Dense vegetation limits the inspector's visibility to identify signs of pipe failure (leaks) along the landward slope.						
Recommend removing vegetation along pipe alignment to conduct proper inspection of structure.						
FIELD_STRUCT_DESC: 48-inch by 60-inch reinforced concrete box gravity drainage culvert through the levee, 14.6 feet below the crown.						
Flap gate on the waterside (WS) end. Concrete headwall on the landside (LS) end. Concrete U-shaped headwall on the WS end.						
[Additional Reference(s): DWR Levee Log, 2002. USACE San Joaquin O&M Manual 601.1, 1967, (HLM 2.58)].						
FS Date: 4/1/2014

Concrete headwall at LS toe.

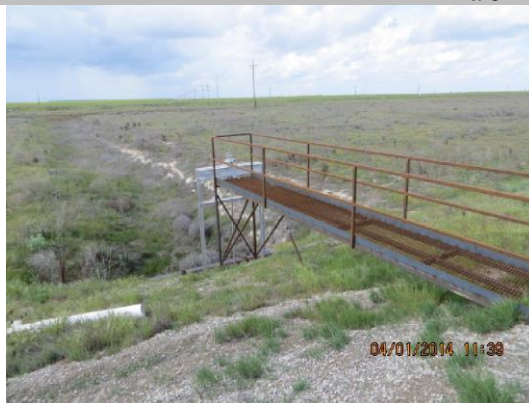
Photo 1 of 3 : UCIP\_SP\_2018\_32998\_59714.jpg

FS\_ID:32998  
 DS\_ID:19921  
 EP\_NO: N/A  
 Repair Type: No Action Needed  
 Crossing Status: Found  
 UCIP Comments:  
 FIELD\_STRUCT\_DESC: 48-inch by 60-inch reinforced concrete box gravity drainage culvert through the levee, 14.6 feet below the crown. Concrete U-shaped headwall on the waterside (WS) end. 36-inch weir structure on the WS. Combination flap gate and slide gate on the WS toe. Steel walkway to slide gate actuator on the WS shoulder. (Plans to construct a 3.281-foot-high weir and attach a cable operated flap valve to an existing 48-inch by 60-inch culvert authorized under Permit No. 13587, 1983 - Clark Brothers Farming, Arroyo Ranch). [Additional Reference(s): DWR Levee Log, 2002. USACE San Joaquin O&M Manual 601.1, 1967, (HLM 4.69)].  
 FS Date: 4/1/2014

Steel walkway to slide gate actuator on WS shoulder.

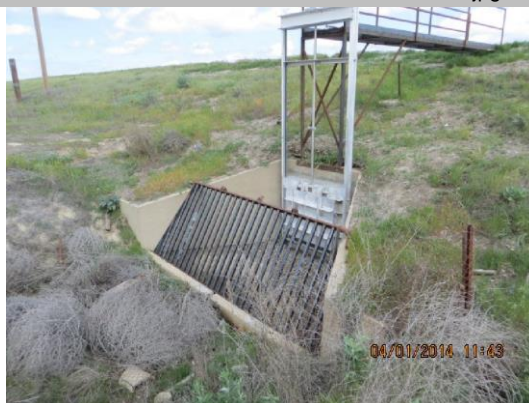
Photo 2 of 3 : UCIP\_SP\_2018\_32998\_59715.jpg

Combination flapgate/slidegate, concrete headwall, and metal screen at WS toe.

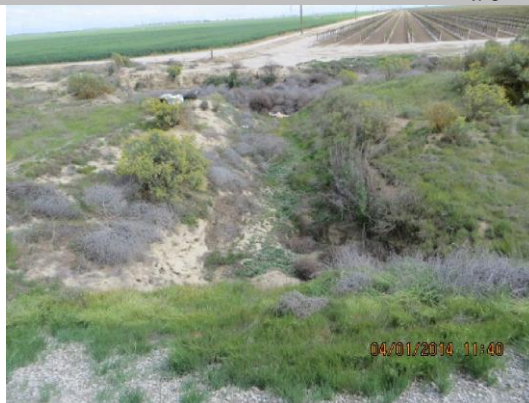
Photo 3 of 3 : UCIP\_SP\_2018\_32998\_59713.jpg

Comment Code						
Inspector Comment						
FS_ID:32998 DS_ID:19921 EP_NO: N/A Repair Type: No Action Needed Crossing Status: Found UCIP Comments: FIELD_STRUCT_DESC: 48-inch by 60-inch reinforced concrete box gravity drainage culvert through the levee, 14.6 feet below the crown. Concrete U-shaped headwall on the waterside (WS) end. 36-inch weir structure on the WS. Combination flap gate and slide gate on the WS toe. Steel walkway to slide gate actuator on the WS shoulder. (Plans to construct a 3.281-foot-high weir and attach a cable operated flap valve to an existing 48-inch by 60-inch culvert authorized under Permit No. 13587, 1983 - Clark Brothers Farming, Arroyo Ranch). [Additional Reference(s): DWR Levee Log, 2002. USACE San Joaquin O&M Manual 601.1, 1967, (HLM 4.69)]. FS Date: 4/1/2014

Concrete headwall on LS toe.

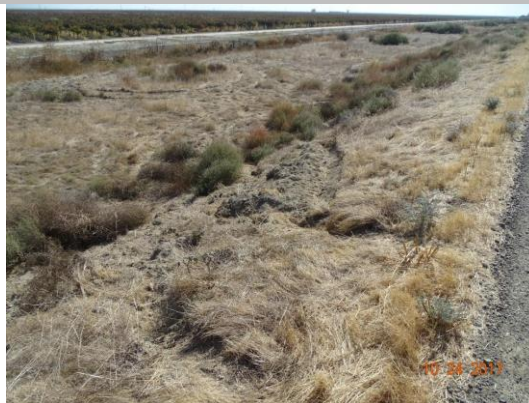
Photo 1 of 1 : SP\_2018\_NA0010\_135\_22\_20180307\_00009.jpg

LM Start	4.74	Rating **	M	Issue No.	22
LM End	4.74	Issue Type +	Ma	Location *	LS
Category	Earthen Levee			GPS Latitude/Longitude	
				Start	End
Item	Slope Stability			36.922526 °	36.922526 °
				-120.336227 °	-120.336227 °
DWR ID	DWR_NA0010_17_f_2017_22				
Comment Code					
S3 : Repair the levee slope damaged by vehicle traffic and prevent access where possible.					
Inspector Comment

Looking southeast at the landside slope.

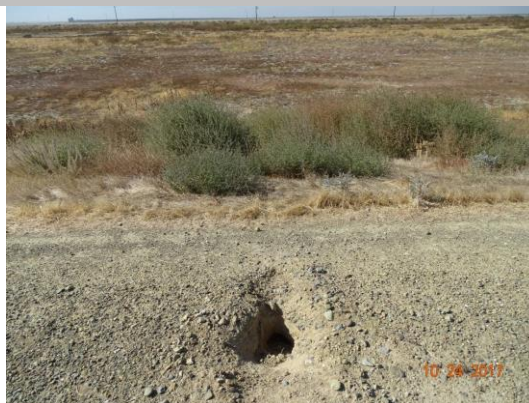
Photo 1 of 1 : SP\_2018\_NA0010\_135\_23\_20180307\_00010.jpg

LM Start	7.41	Rating **	M	Issue No.	23
LM End	7.41	Issue Type +	Ma	Location *	CR
Category	Earthen Levee			GPS Latitude/Longitude	
				Start	End
Item	Animal Control			36.885998 °	36.885998 °
				-120.320759 °	-120.320759 °
DWR ID	DWR_NA0010_17_f_2017_23				
Comment Code					
A3 : No rodents visible, but rodent burrows visible; need to backfill and compact or grout burrows.					
Inspector Comment

Looking southwest at the crown.

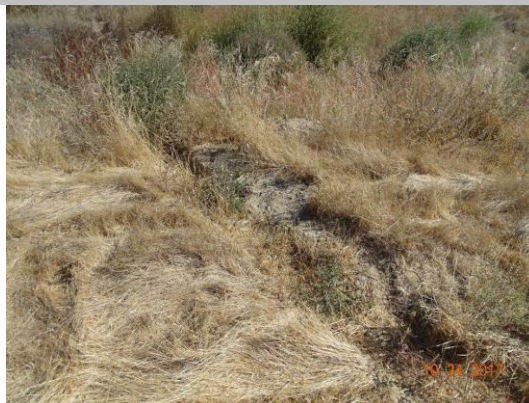
Photo 1 of 1 : SP\_2018\_NA0010\_135\_24\_20180307\_00011.jpg

LM Start	8.15	Rating **	M	Issue No.	24
LM End	8.15	Issue Type +	Ma	Location *	LS
Category	Earthen Levee			GPS Latitude/Longitude	
				Start	End
Item	Animal Control			36.875525 °	36.875525 °
				-120.317788 °	-120.317788 °
DWR ID	DWR_NA0010_17_f_2017_24				
Comment Code					
A3 : No rodents visible, but rodent burrows visible; need to backfill and compact or grout burrows.					
Inspector Comment					
Rodent holes on landside and crown of levee. Rodent holes have caused some erosion on the landside slope.

Looking east at the landside slope.

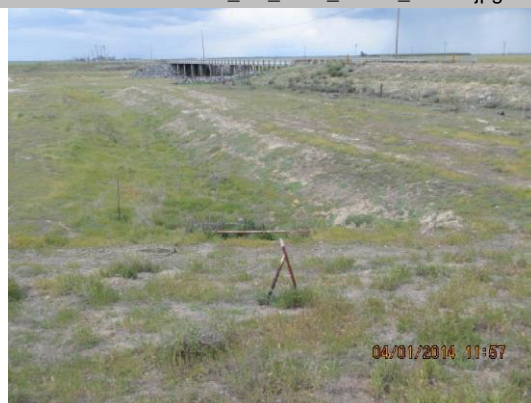
Photo 1 of 3 : UCIP\_SP\_2018\_32999\_59718.jpg

LM Start	8.37	Rating **	A/W	Issue No.	27
LM End	8.37	Issue Type +	Ma	Location *	
Category	Supplemental			GPS Latitude/Longitude	
				Start	End
Item	DWR UCIP LMA Responsibility			36.872358 °	36.872358 °
				-120.317170 °	-120.317170 °
DWR ID					
Comment Code					
Inspector Comment					
FS_ID:32999					
DS_ID:19922					
EP_NO: N/A					
Repair Type: No Action Needed					
Crossing Status: Found					
UCIP Comments:					
FIELD_STRUCT_DESC: 48-inch by 60-inch reinforced concrete box gravity drainage culvert through the levee, 16.5 feet below the crown. Flap gate on the waterside (WS) end. Concrete headwall on the landside (LS) end. Concrete U-shaped headwall on the WS end. [Additional Reference(s): DWR Levee Log, 2002. USACE San Joaquin O&M Manual 601.1, 1967, (HLM 8.38)].					
FS Date: 4/1/2014

Concrete headwall and channel on WS toe.

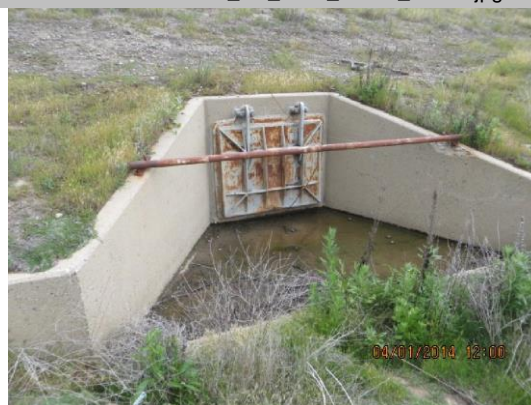
Photo 2 of 3 : UCIP\_SP\_2018\_32999\_59720.jpg

Flapgate on concrete headwall at WS toe.

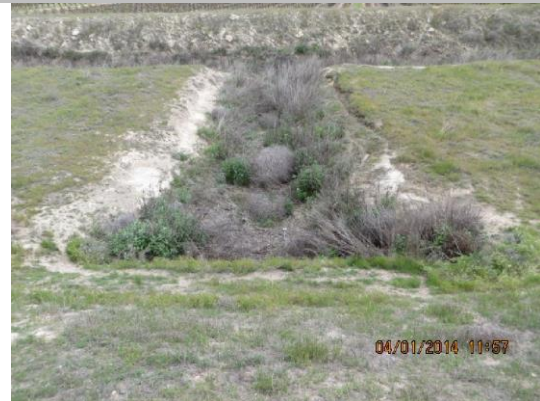
Photo 3 of 3 : UCIP\_SP\_2018\_32999\_59719.jpg

LM Start	8.37	Rating **	A/W	Issue No.	27 (cont)	
LM End	8.37	Issue Type +	Ma	Location *		
Category	Supplemental			GPS Latitude/Longitude		
				Start	End	
Item	DWR UCIP LMA Responsibility			36.872358 °	36.872358 °	
				-120.317170 °	-120.317170 °	
DWR ID						
Comment Code						
Inspector Comment						
FS_ID:32999						
DS_ID:19922						
EP_NO: N/A						
Repair Type: No Action Needed						
Crossing Status: Found						
UCIP Comments:						
FIELD_STRUCT_DESC: 48-inch by 60-inch reinforced concrete box gravity drainage culvert through the levee, 16.5 feet below the crown. Flap gate on the waterside (WS) end. Concrete headwall on the landside (LS) end. Concrete U-shaped headwall on the WS end. [Additional Reference(s): DWR Levee Log, 2002. USACE San Joaquin O&M Manual 601.1, 1967, (HLM 8.38)].						
FS Date: 4/1/2014

Concrete headwall and channel on LS toe.

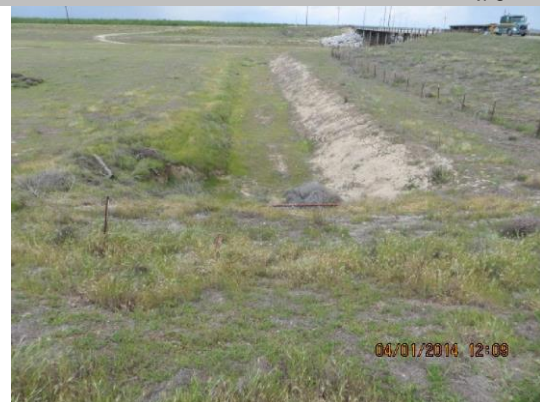
Photo 1 of 3 : UCIP\_SP\_2018\_39532\_59723.jpg

Comment Code						
Inspector Comment						
FS_ID:39532 DS_ID:19917 EP_NO: N/A Repair Type: Non-Urgent Crossing Status: Found UCIP Comments: Dense vegetation limits the inspector's visibility to identify signs of pipe failure (leaks) along the landward slope. Recommend removing vegetation along pipe alignment to conduct proper inspection of structure. FIELD_STRUCT_DESC: 48-inch by 60-inch reinforced concrete box gravity drainage culvert through the levee, 15 feet below the crown. Concrete headwall on the landside (LS) end. Concrete U-shaped headwall on the waterside (WS) end. [Additional Reference(s): DWR Levee Log, 2002. USACE San Joaquin O&M Manual 601.1, 1967, (HLM 9.89)]. FS Date: 4/1/2014

Concrete headwall and channel on WS toe.

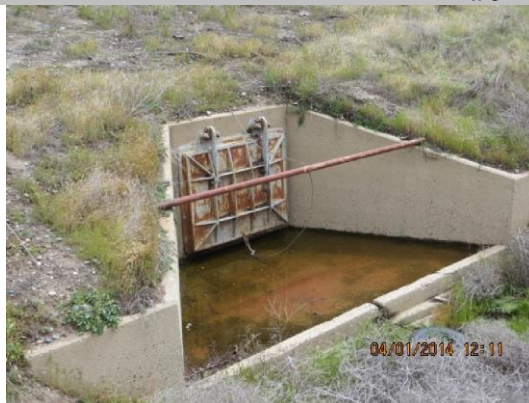
Photo 2 of 3 : UCIP\_SP\_2018\_39532\_59724.jpg

Comment Code						
Inspector Comment						
FS_ID:39532						
DS_ID:19917						
EP_NO: N/A						
Repair Type: Non-Urgent						
Crossing Status: Found						
UCIP Comments: Dense vegetation limits the inspector's visibility to identify signs of pipe failure (leaks) along the landward slope.						
Recommend removing vegetation along pipe alignment to conduct proper inspection of structure.						
FIELD_STRUCT_DESC: 48-inch by 60-inch reinforced concrete box gravity drainage culvert through the levee, 15 feet below the crown.						
Concrete headwall on the landside (LS) end. Concrete U-shaped headwall on the waterside (WS) end. [Additional Reference(s): DWR Levee Log, 2002. USACE San Joaquin O&M Manual 601.1, 1967, (HLM 9.89)].						
FS Date: 4/1/2014

Flapgate on Concrete headwall at WS toe.

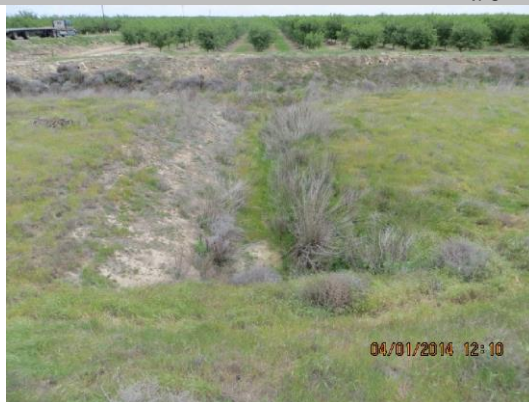
Photo 3 of 3 : UCIP\_SP\_2018\_39532\_59722.jpg

Concrete headwall and channel on LS toe.

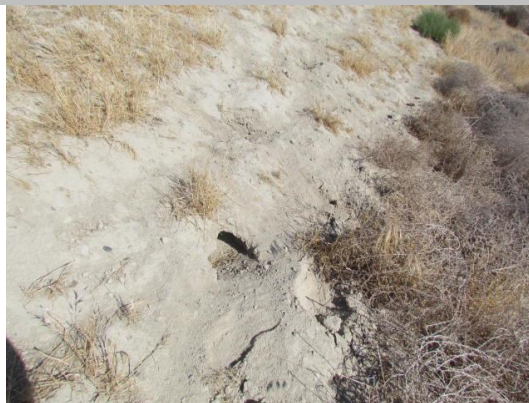
Photo 1 of 2 : SP\_2018\_NA0010\_135\_3\_20180307\_00001.jpg

Looking at typical view of rodent holes on landward slope. Fall 2015

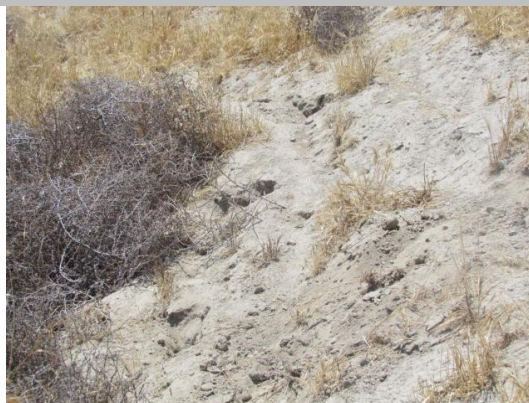
Photo 2 of 2 : SP\_2018\_NA0010\_135\_3\_20180307\_00002.jpg

Looking at several rodent holes on landward slope. Spring 2015

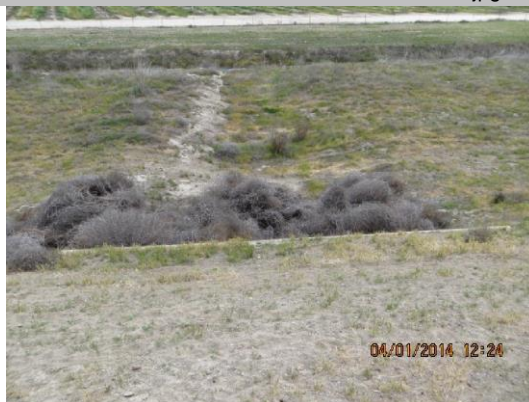
Photo 2 of 3 : UCIP\_SP\_2018\_39533\_59726.jpg

Concrete headwall on LS toe.

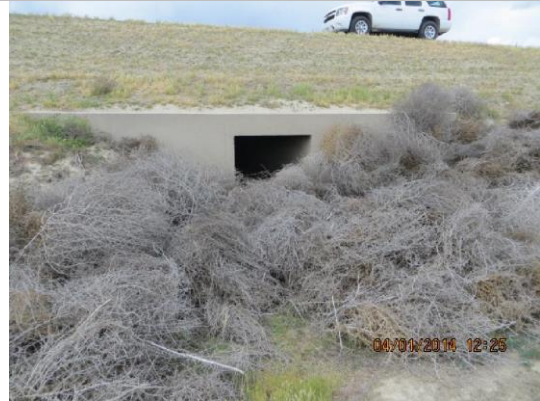
Photo 3 of 3 : UCIP\_SP\_2018\_39533\_59725.jpg

LM Start	13.29	Rating **	M	Issue No.	29 (cont)	
LM End	13.29	Issue Type +	Ma	Location *		
Category	Supplemental			GPS Latitude/Longitude		
				Start	End	
Item	DWR UCIP LMA Responsibility			36.807509 °	36.807509 °	
				-120.306231 °	-120.306231 °	
DWR ID						
Comment Code						
Inspector Comment						
FS_ID:39533						
DS_ID:19918						
EP_NO: N/A						
Repair Type: Non-Urgent						
Crossing Status: Found						
UCIP Comments: Some vegetation buildup at inlet--recommend clearing.						
FIELD_STRUCT_DESC: 48-inch by 60-inch reinforced concrete box gravity drainage culvert through the levee, 15.3 feet below the crown. Flap gate on the waterside (WS) end. Concrete headwall on the landside (LS) end. Concrete U-shaped headwall on the WS end. [Additional Reference(s): DWR Levee Log, 2002. USACE San Joaquin O&M Manual 601.1, 1967, (HLM 13.30)].						
FS Date: 4/1/2014

Concrete headwall on LS toe. Some vegetation buildup.

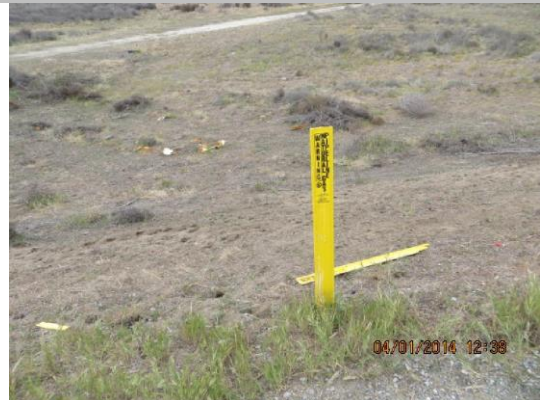
Photo 1 of 3 : UCIP\_SP\_2018\_41406\_71490.jpg

LM Start	14.38	Rating **	M	Issue No.	30
LM End	14.38	Issue Type +	En	Location *	
Category	Supplemental			GPS Latitude/Longitude	
				Start	End
Item	DWR UCIP Field Study			36.793318 °	36.793318 °
				-120.302138 °	-120.302138 °
DWR ID					
Comment Code					
Inspector Comment					
FS_ID:41406 DS_ID:24850 EP_NO: N/A Repair Type: Non-Urgent Crossing Status: Indicator Found UCIP Comments: No permit identified for this crossing. FIELD_STRUCT_DESC: Natural gas pipeline of an unknown size or material through the levee, at an unknown depth. Gas line markers on both shoulders. FS Date: 4/1/2014

Gasline marker on WS slope..

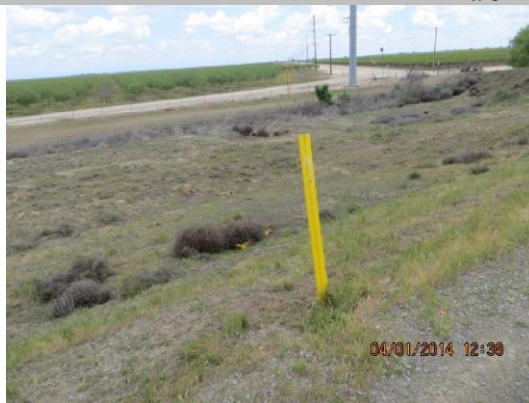
Photo 2 of 3 : UCIP\_SP\_2018\_41406\_71489.jpg

LM Start	14.38	Rating **	M	Issue No.	30 (cont)
LM End	14.38	Issue Type +	En	Location *	
Category	Supplemental			GPS Latitude/Longitude	
				Start	End
Item	DWR UCIP Field Study			36.793318 °	36.793318 °
				-120.302138 °	-120.302138 °
DWR ID					
Comment Code					
Inspector Comment					
FS_ID:41406 DS_ID:24850 EP_NO: N/A Repair Type: Non-Urgent Crossing Status: Indicator Found UCIP Comments: No permit identified for this crossing. FIELD_STRUCT_DESC: Natural gas pipeline of an unknown size or material through the levee, at an unknown depth. Gas line markers on both shoulders. FS Date: 4/1/2014

Gasline marker on LS shoulder.

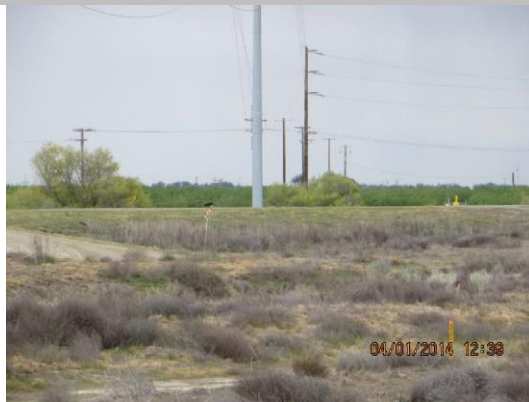
Photo 3 of 3 : UCIP\_SP\_2018\_41406\_71488.jpg

Gasline markers visible along right side of photo.

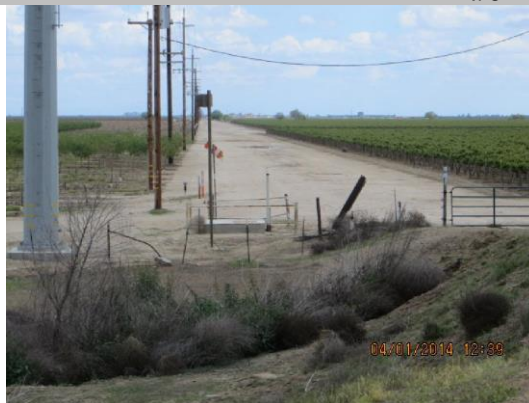
Photo 1 of 3 : UCIP\_SP\_2018\_50067\_59742.jpg

Comment Code					
Inspector Comment					
FS_ID:50067 DS_ID:19562 EP_NO: 18568 Repair Type: Non-Urgent Crossing Status: Indicator Found UCIP Comments: 7/20/2016 Marker visible on LS. WS marker missing. (DWR UCIP - omagana)4/01/2014 Need to contact owner to confirm and obtain status of crossing. Markers misleading--unable to confirm if markers correspond to this crossing. Need markers at levee. (DWR UCIP - omagana) FIELD_STRUCT_DESC: 30-inch coated steel natural gas pipeline through the levee, approximately 60 feet below the crown. Gas line markers are visible on the waterside (WS) and the landside (LS). (30-inch horizontal directional bore (HDD) authorized under Permit No. 18568, 2010 - Gill Ranch Storage, LLC). FS Date: 7/20/2016

Gasline marker and concrete sump off LS toe.

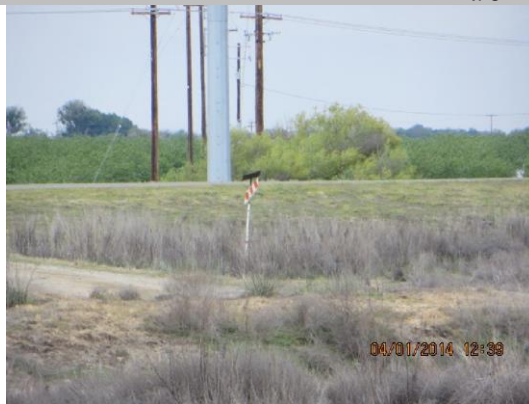
Photo 2 of 3 : UCIP\_SP\_2018\_50067\_59741.jpg

Gasline marker visible in channel off WS toe.

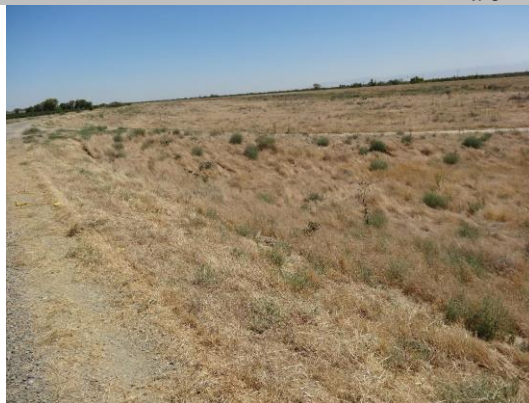
Photo 3 of 3 : UCIP\_SP\_2018\_50067\_75506.jpg

Comment Code						
Inspector Comment						
FS_ID:50067 DS_ID:19562 EP_NO: 18568 Repair Type: Non-Urgent Crossing Status: Indicator Found UCIP Comments: 7/20/2016 Marker visible on LS. WS marker missing. (DWR UCIP - omagana)4/01/2014 Need to contact owner to confirm and obtain status of crossing. Markers misleading--unable to confirm if markers correspond to this crossing. Need markers at levee. (DWR UCIP - omagana) FIELD_STRUCT_DESC: 30-inch coated steel natural gas pipeline through the levee, approximately 60 feet below the crown. Gas line markers are visible on the waterside (WS) and the landside (LS). (30-inch horizontal directional bore (HDD) authorized under Permit No. 18568, 2010 - Gill Ranch Storage, LLC). FS Date: 7/20/2016

View of WS.

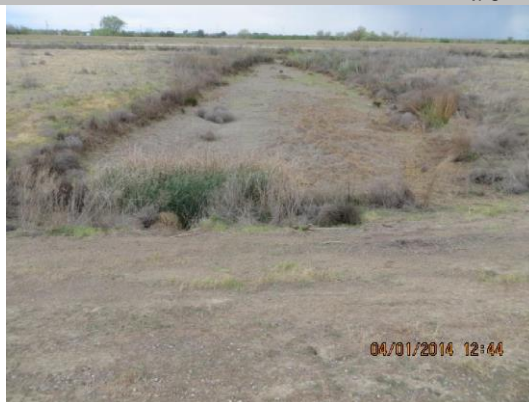
Photo 1 of 3 : UCIP\_SP\_2018\_39535\_59745.jpg

LM Start	14.69	Rating **	M	Issue No.	32
LM End	14.69	Issue Type +	Ma	Location *	
Category	Supplemental			GPS Latitude/Longitude	
				Start	End
Item	DWR UCIP LMA Responsibility			36.789066 °	36.789066 °
				-120.300644 °	-120.300644 °
DWR ID					
Comment Code					
Inspector Comment					
FS_ID:39535					
DS_ID:19920					
EP_NO: N/A					
Repair Type: Non-Urgent					
Crossing Status: Found					
UCIP Comments: Heavy vegetation buildup at LS toe--recommend clearing.					
FIELD_STRUCT_DESC: 30-inch by 30-inch square reinforced concrete box gravity drainage culvert through the levee, 14 feet below the crown. Flap gate on the waterside (WS) end. Concrete headwall on the landside (LS) end. Concrete U-shaped headwall on the WS end.					
[Additional Reference(s): DWR Levee Log, 2002. USACE San Joaquin O&M Manual 601.1, 1967, (HLM 14.69)].					
FS Date: 4/1/2014

Concrete headwall at WS toe.

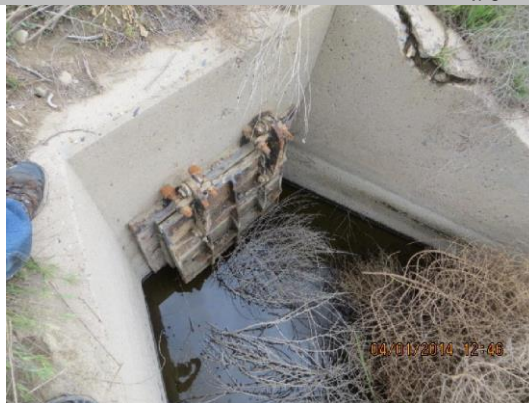
Photo 2 of 3 : UCIP\_SP\_2018\_39535\_59747.jpg

LM Start	14.69	Rating **	M	Issue No.	32 (cont)	
LM End	14.69	Issue Type +	Ma	Location *		
Category	Supplemental			GPS Latitude/Longitude		
				Start		End
Item	DWR UCIP LMA Responsibility			36.789066 °	36.789066 °	
				-120.300644 °	-120.300644 °	
DWR ID						
Comment Code						
Inspector Comment						
FS_ID:39535						
DS_ID:19920						
EP_NO: N/A						
Repair Type: Non-Urgent						
Crossing Status: Found						
UCIP Comments: Heavy vegetation buildup at LS toe--recommend clearing.						
FIELD_STRUCT_DESC: 30-inch by 30-inch square reinforced concrete box gravity drainage culvert through the levee, 14 feet below the crown. Flap gate on the waterside (WS) end. Concrete headwall on the landside (LS) end. Concrete U-shaped headwall on the WS end.						
[Additional Reference(s): DWR Levee Log, 2002. USACE San Joaquin O&M Manual 601.1, 1967, (HLM 14.69)].						
FS Date: 4/1/2014

Flapgate on Concrete headwall at WS toe.

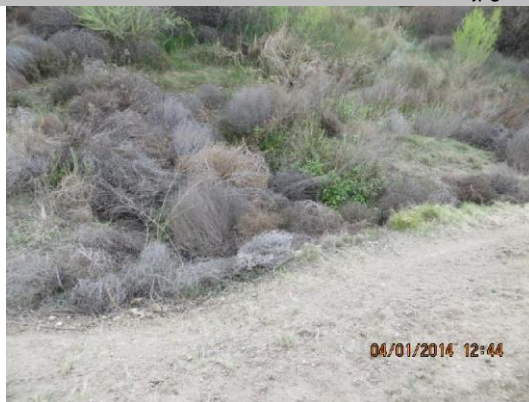
Photo 3 of 3 : UCIP\_SP\_2018\_39535\_59746.jpg

Concrete headwall at channel on LS toe. Heavy vegetation buildup.
