**Flood Control Project Maintenance  
Levee Inspections**  
**LMA District Cover Sheet**  
**Spring 2018 Levee Inspection Results**

**Lower San Joaquin Levee District**

**Spring 2018 Levee Inspection Results**

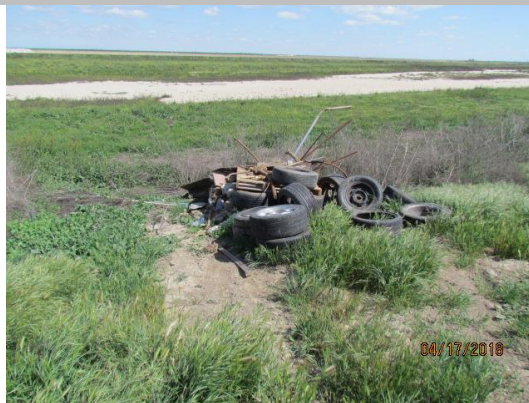
Photo 1 of 1 : SP\_2018\_NA0010\_137\_20\_20180420\_00022.jpg

LM Start	0.58	Rating **	U	Issue No.	20
LM End	0.58	Issue Type +	Ma	Location *	WS
Category	Earthen Levee			GPS Latitude/Longitude	
				Start	End
Item	Encroachments			36.967678 °	36.967678 °
				-120.357660 °	-120.357660 °
DWR ID	DWR_NA0010_18_s_2018_20				
Comment Code					
GA : Garbage					
Inspector Comment					
Garbage (rubber tires) stockpile on waterward slope.

Looking east at garbage (rubble tires) on waterward slope. (Spring 2018)

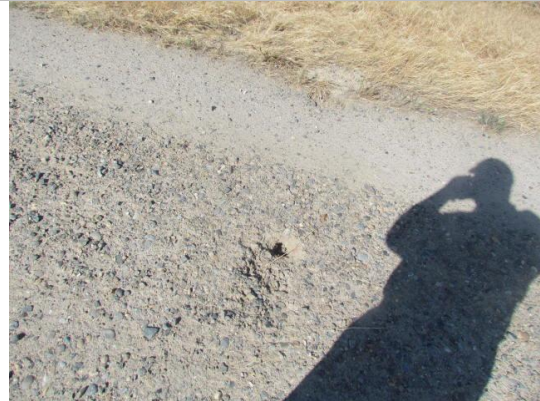
Photo 1 of 1 : SP\_2018\_NA0010\_137\_7\_20180307\_00003.jpg

LM Start	1.44	Rating **	M	Issue No.	7
LM End	1.44	Issue Type +	Ma	Location *	LS
Category	Earthen Levee			GPS Latitude/Longitude	
				Start	End
Item	Animal Control			36.956163 °	36.956163 °
				-120.353672 °	-120.353672 °
DWR ID	DWR_NA0010_18_s_2014_7				
Comment Code					
A3 : No rodents visible, but rodent burrows visible; need to backfill and compact or grout burrows.					
Inspector Comment					
Several holes identified on landside slope and on the levee crown.

Looking at typical view of rodent holes within this section on landward slope.

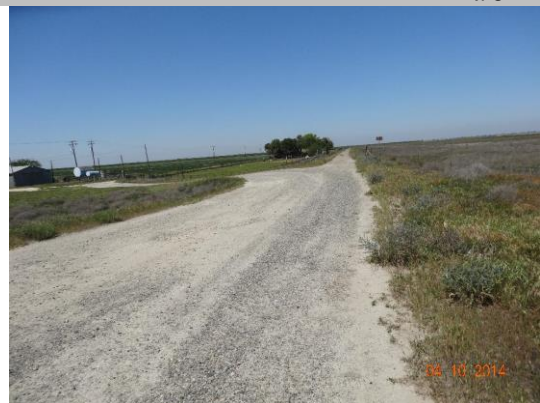
Photo 1 of 3 : UCIP\_SP\_2018\_39503\_66660.jpg

Comment Code					
Inspector Comment					
FS_ID:39503 DS_ID:19925 EP_NO: 6603 Repair Type: Non-Urgent Crossing Status: Found UCIP Comments: Need to contact owner. Appears abandoned--good candidate for video or pressure inspection. This crossings is the same age as the pipe that has failed immediately upstream. FIELD_STRUCT_DESC: 15-inch steel irrigation discharge pipe through the levee, 4.3 feet below the crown. Electrical conduit of an unknown size or material through the levee, 4.3 feet below the crown. Siphon breaker on the landside (LS) shoulder. 36-inch concrete standpipe on the LS berm. Inlet facility on the waterside (WS) bank consisting of a pump, a 42-inch concrete standpipe, and a 20-inch concrete channel with an intake pipe and a cutoff wall. (Plans to install a pump and outlet pipe at two locations on the left bank levee of the Chowchilla Bypass authorized under Permit No. 6603, 1969 - Raymond N. Costales). [Additional Reference(s): DWR Levee Log, 2002]. FS Date: 4/10/2014

Overview of levee crown at crossing.

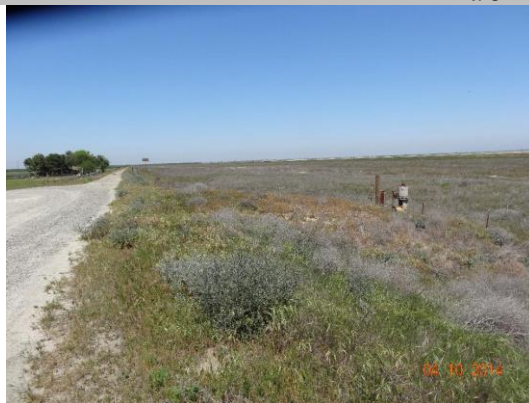
Photo 2 of 3 : UCIP\_SP\_2018\_39503\_66657.jpg

View of waterward side.

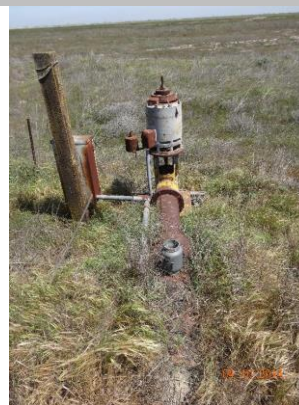
Photo 3 of 3 : UCIP\_SP\_2018\_39503\_66658.jpg

Pump system located on waterward slope.

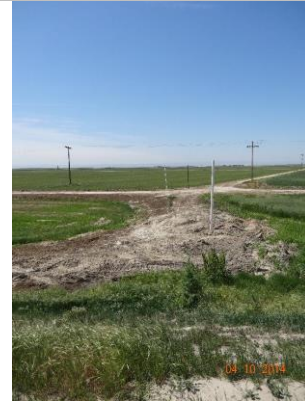
Photo 1 of 3 : UCIP\_SP\_2018\_49968\_60558.jpg

Comment Code						
Inspector Comment						
FS_ID:49968						
DS_ID:19926						
EP_NO: 6603						
Repair Type: Non-Urgent						
Crossing Status: Found						
UCIP Comments: 7/20/2016 High burrow activity. Dense vegetation limits the inspector's visibility to identify signs of pipe failure (leaks) along the WS and LS slope. Recommend removing vegetation along pipe alignment to conduct proper inspection of structure and appurtenances. (DWR UCIP - omagana)4/10/2014 Subsidence present along pipe alignment on landward side. Modified crossing--worked done on landward side. Need to contact owner to determine permit authorizing work. Dense vegetation on landward side--tall grass. Pipe wall cut and new pipe sleeved on landward side. (DWR UCIP - omagana)						
FIELD_STRUCT_DESC: 15-inch steel irrigation discharge pipe and electrical conduit through the levee, 3.7 feet below the crown. Siphon breaker on the landside (LS) shoulder. 36-inch concrete standpipe on the LS berm. Inlet facility on the riverbank, consisting of a pump, a 42-inch concrete standpipe, and a 20-inch concrete channel with an intake pipe and a cutoff wall. (Plans to install a pump and outlet pipe at two locations on the left bank levee of the Chowchilla Bypass authorized under Permit No. 6603, 1969 - Raymond N. Costales). [Additional Reference(s): DWR Levee Log, 2002].

Overview of LS--site modified.

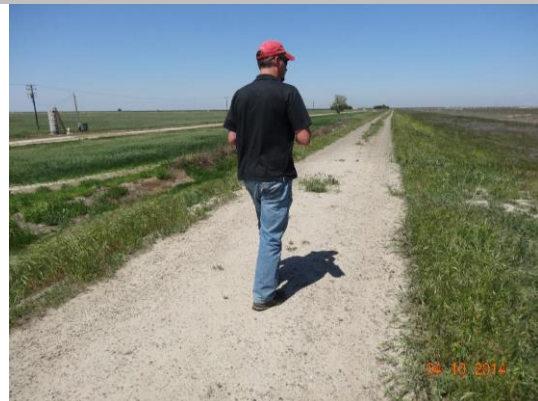
Photo 2 of 3 : UCIP\_SP\_2018\_49968\_60559.jpg

View of levee crown at crossing.

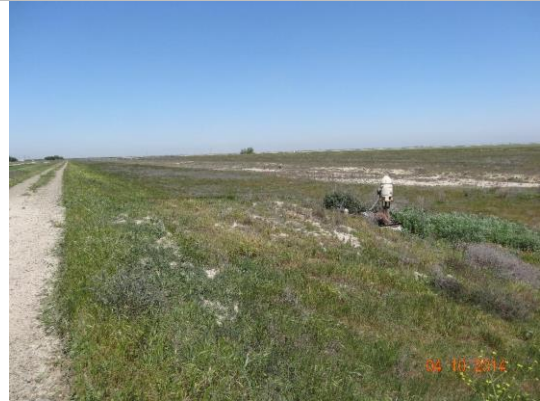
Photo 3 of 3 : UCIP\_SP\_2018\_49968\_60560.jpg

Comment Code						
Inspector Comment						
FS_ID:49968 DS_ID:19926 EP_NO: 6603 Repair Type: Non-Urgent Crossing Status: Found UCIP Comments: 7/20/2016 High burrow activity. Dense vegetation limits the inspector's visibility to identify signs of pipe failure (leaks) along the WS and LS slope. Recommend removing vegetation along pipe alignment to conduct proper inspection of structure and appurtenances. (DWR UCIP - omagana)4/10/2014 Subsidence present along pipe alignment on landward side. Modified crossing--worked done on landward side. Need to contact owner to determine permit authorizing work. Dense vegetation on landward side--tall grass. Pipe wall cut and new pipe sleeved on landward side. (DWR UCIP - omagana) FIELD_STRUCT_DESC: 15-inch steel irrigation discharge pipe and electrical conduit through the levee, 3.7 feet below the crown. Siphon breaker on the landside (LS) shoulder. 36-inch concrete standpipe on the LS berm. Inlet facility on the riverbank, consisting of a pump, a 42-inch concrete standpipe, and a 20-inch concrete channel with an intake pipe and a cutoff wall. (Plans to install a pump and outlet pipe at two locations on the left bank levee of the Chowchilla Bypass authorized under Permit No. 6603, 1969 - Raymond N. Costales). [Additional Reference(s): DWR Levee Log, 2002]. FS Date: 7/20/2016

View of WS.

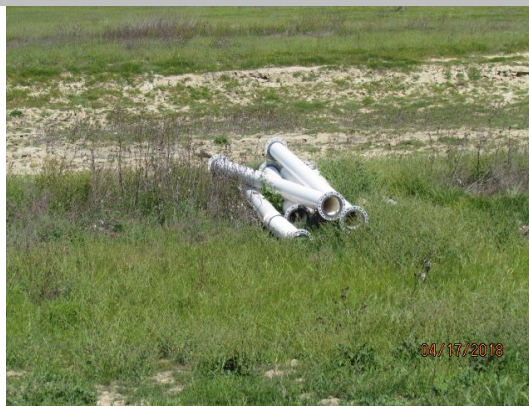
Photo 1 of 1 : SP\_2018\_NA0010\_137\_17\_20180420\_00023.jpg

LM Start	3.68	Rating **	M	Issue No.	17
LM End	3.68	Issue Type +	Ma	Location *	WS
Category	Earthen Levee			GPS Latitude/Longitude	
				Start	End
Item	Encroachments			36.925683 °	36.925683 °
				-120.339692 °	-120.339692 °
DWR ID	DWR_NA0010_18_s_2018_17				
Comment Code					
PI : Pipe					
Inspector Comment					
Remove Irrigation pipes stored in channel.

Looking east at irrigation pipe stored in channel. (Spring 2018)

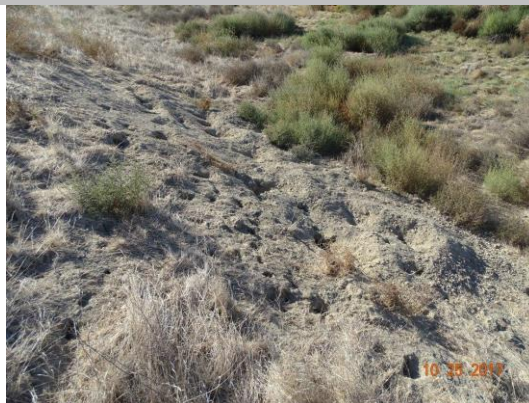
Photo 1 of 1 : SP\_2018\_NA0010\_137\_1\_20180307\_00001.jpg

LM Start	5.89	Rating **	U	Issue No.	1
LM End	5.89	Issue Type +	Ma	Location *	LS
Category	Earthen Levee			GPS Latitude/Longitude	
				Start	End
Item	Animal Control			36.895175 °	36.895175 °
				-120.327632 °	-120.327632 °
DWR ID	DWR_NA0010_18_s_2015_1				
Comment Code					
A3 : No rodents visible, but rodent burrows visible; need to backfill and compact or grout burrows.					
Inspector Comment					
Several large rodent holes noted on landside slope and berm within this section.

Looking at the landside slope.

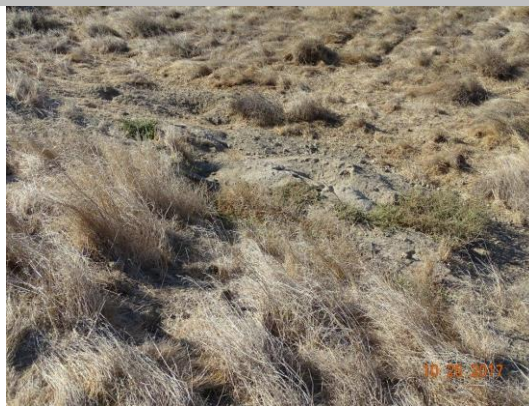
Photo 1 of 1 : SP\_2018\_NA0010\_137\_15\_20180307\_00008.jpg

LM Start	5.99	Rating **	U	Issue No.	15
LM End	5.99	Issue Type +	Ma	Location *	LS
Category	Earthen Levee			GPS Latitude/Longitude	
				Start	End
Item	Animal Control			36.893924 °	36.893924 °
				-120.327020 °	-120.327020 °
DWR ID	DWR_NA0010_18_f_2017_15				
Comment Code					
A3 : No rodents visible, but rodent burrows visible; need to backfill and compact or grout burrows.					
Inspector Comment					
Multiple large rodent holes at the landside toe.

Looking west at the landside slope.

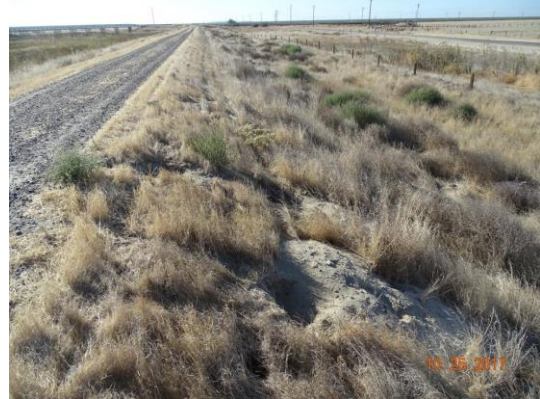
Photo 1 of 1 : SP\_2018\_NA0010\_137\_14\_20180307\_00007.jpg

LM Start	7.39	Rating **	U	Issue No.	14
LM End	7.53	Issue Type +	Ma	Location *	LS
Category	Earthen Levee			GPS Latitude/Longitude	
				Start	End
Item	Animal Control			36.874479 °	36.872503 °
				-120.319831 °	-120.319438 °
DWR ID	DWR_NA0010_18_f _ 2017_14				
Comment Code					
A3 : No rodents visible, but rodent burrows visible; need to backfill and compact or grout burrows.					
Inspector Comment					
Several rodent holes noted along landside slope in this area.

Looking south at the landside slope.

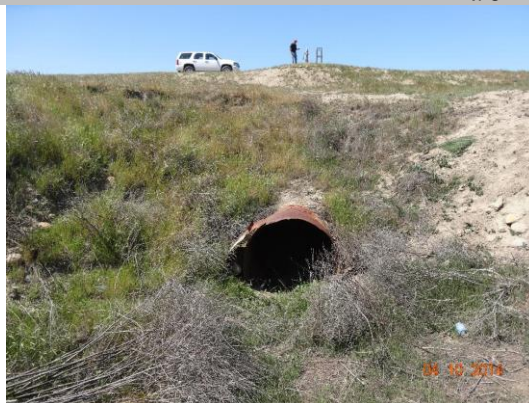
Photo 2 of 3 : UCIP\_SP\_2018\_36843\_67205.jpg

FS\_ID:36843  
DS\_ID:19930  
EP\_NO: N/A  
Repair Type: Non-Urgent  
Crossing Status: Found  
UCIP Comments: CMP crossing is distorted on waterward side. Debris scattered on landward side. Sediment deposit inside crossing visible from landward side. Recommend removing debris from landward side.  
FIELD\_STRUCT\_DESC: 42-inch reinforced concrete gravity irrigation pipe through the levee, 19 feet below the crown. Gate structure on the waterside (WS) shoulder. Pipe section on the WS is corrugated metal. Pipe section on the landside (LS) is reinforced concrete. (Plans to install a 42-inch gravity-flow concrete pipeline through the left bank levee of the Eastside Bypass to divert bypass waters for irrigation purposes authorized under Permit No. 13548, 1983 - New Stone Water District). [Additional Reference(s): DWR Levee Log, 2002].  
FS Date: 4/10/2014

Pipe section distorted on waterward side.

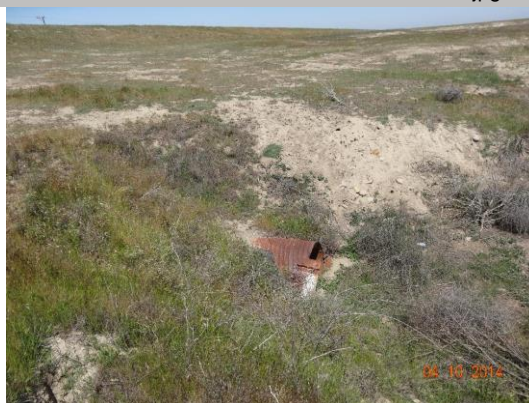
Photo 3 of 3 : UCIP\_SP\_2018\_36843\_67200.jpg

CMP section visible on waterward side.

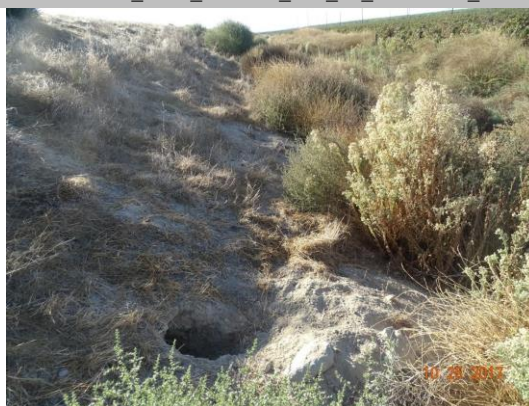
Photo 1 of 1 : SP\_2018\_NA0010\_137\_13\_20180307\_00006.jpg

LM Start	8.67	Rating **	U	Issue No.	13
LM End	8.67	Issue Type +	Ma	Location *	LS
Category	Earthen Levee			GPS Latitude/Longitude	
				Start	End
Item	Animal Control			36.856115 °	36.856115 °
				-120.316595 °	-120.316595 °
DWR ID	DWR_NA0010_18_f_2017_13				
Comment Code					
A3 : No rodents visible, but rodent burrows visible; need to backfill and compact or grout burrows.					
Inspector Comment

Looking south at the landside slope.

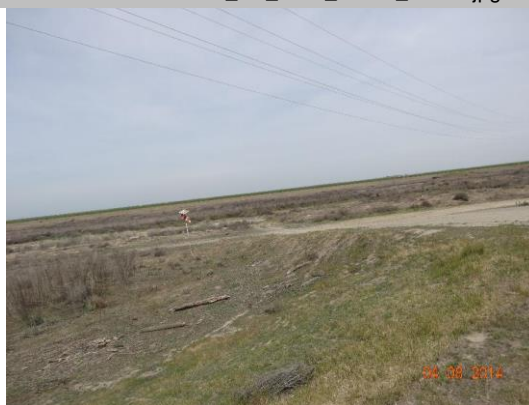
Photo 1 of 3 : UCIP\_SP\_2018\_39505\_67226.jpg

LM Start	13.59	Rating **	M	Issue No.	24
LM End	13.59	Issue Type +	En	Location *	
Category	Supplemental			GPS Latitude/Longitude	
				Start	End
Item	DWR UCIP Field Study			36.792684 °	36.792684 °
				-120.304542 °	-120.304542 °
DWR ID					
Comment Code					
Inspector Comment					
FS_ID:39505					
DS_ID:19932					
EP_NO: N/A					
Repair Type: Non-Urgent					
Crossing Status: Indicator Found					
UCIP Comments: Multiple markers visible along waterward and landward sides unable to confirm how many crossings go through levee. Need to contact owner to obtain additional details on crossings.					
FIELD_STRUCT_DESC: 6-inch natural gas pipeline of an unknown material through the levee. Pipeline extends underneath the channel.					
[Additional Reference(s): DWR Levee Log, 2002].					
FS Date: 4/8/2014

Markers visible on waterward side.

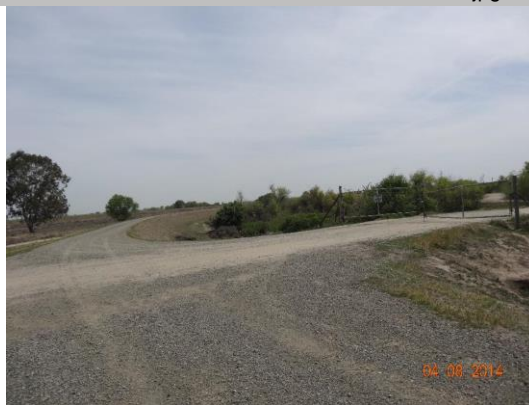
Photo 3 of 3 : UCIP\_SP\_2018\_39505\_67224.jpg

Ramp visible on landward side.

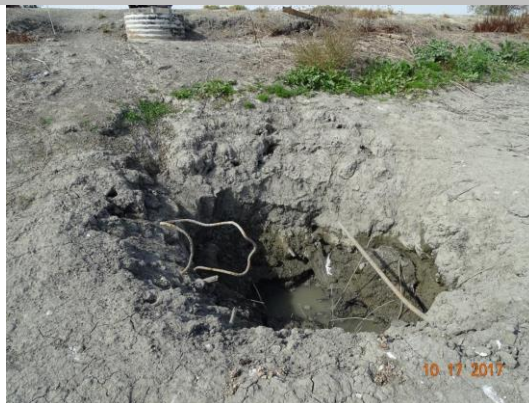
Photo 1 of 2 : SP\_2018\_NA0010\_138\_18\_20180307\_00016.jpg

LM Start	0.10	Rating **	U	Issue No.	18
LM End	0.10	Issue Type +	Ma	Location *	WS
Category	Earthen Levee			GPS Latitude/Longitude	
				Start	End
Item	Erosion / Bank Caving			37.207017 °	37.207017 °
				-120.696261 °	-120.696261 °
DWR ID	DWR_NA0010_22A_f_ 2017_18				
Comment Code					
E2 : Schedule repair of erosion site prior to the next inspection.					
Inspector Comment					
Sinkhole on waterside at pipe location.

Looking west at waterside sinkhole.

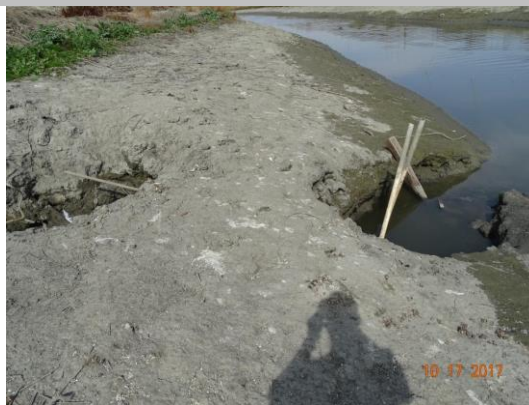
Photo 2 of 2 : SP\_2018\_NA0010\_138\_18\_20180307\_00017.jpg

Looking north at the waterside slope.

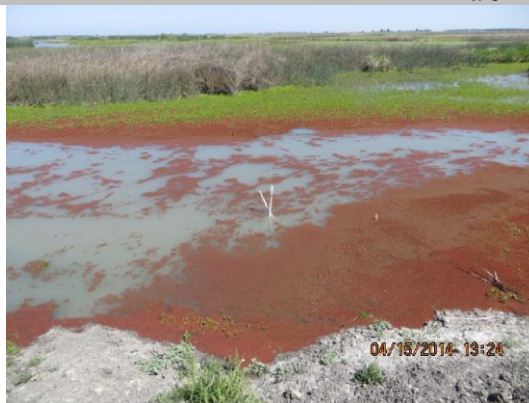
Photo 1 of 3 : UCIP\_SP\_2018\_49959\_61060.jpg

Comment Code						
Inspector Comment						
FS_ID:49959 DS_ID:19933 EP_NO: N/A Repair Type: Non-Urgent Crossing Status: Found UCIP Comments: 07/19/2016 Gate inside riser appears operable--riser lid damage. Crossing is not visible on LS due to dense vegetation. Recommend clearing dense vegetation along WS and LS slope and repairing riser cover. (DWR UCIP - omagana)04/15/2014 No actuator wheel on slide gate at WS shoulder. (DWR UCIP - omagana) FIELD_STRUCT_DESC: 24-inch corrugated metal gravity drainage pipe through the levee, 14.8 feet below the crown. Slide gate in a 36-inch corrugated metal pipe (CMP) riser on the waterside (WS) slope. Concrete U-shaped headwall on each end. [Additional Reference(s): DWR Levee Log, 2002. USACE San Joaquin O&M Manual 601.1, 1967, (HLM 0.10)]. FS Date: 7/19/2016

PVC pipes sticking up out of channel likely indicate pipe location on WS toe.

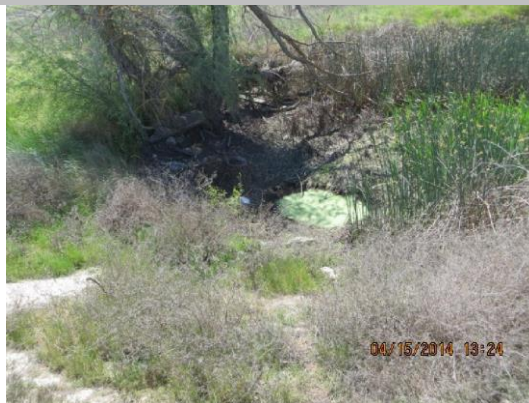
Photo 2 of 3 : UCIP\_SP\_2018\_49959\_61061.jpg

Concrete headwall at toe of LS slope.

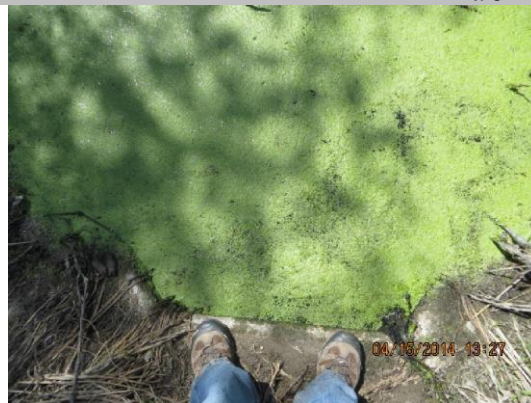
Photo 3 of 3 : UCIP\_SP\_2018\_49959\_61059.jpg

Comment Code						
Inspector Comment						
FS_ID:49959						
DS_ID:19933						
EP_NO: N/A						
Repair Type: Non-Urgent						
Crossing Status: Found						
UCIP Comments: 07/19/2016 Gate inside riser appears operable--riser lid damage. Crossing is not visible on LS due to dense vegetation. Recommend clearing dense vegetation along WS and LS slope and repairing riser cover. (DWR UCIP - omagana)04/15/2014 No actuator wheel on slide gate at WS shoulder. (DWR UCIP - omagana)						
FIELD_STRUCT_DESC: 24-inch corrugated metal gravity drainage pipe through the levee, 14.8 feet below the crown. Slide gate in a 36-inch corrugated metal pipe (CMP) riser on the waterside (WS) slope. Concrete U-shaped headwall on each end. [Additional Reference(s): DWR Levee Log, 2002. USACE San Joaquin O&M Manual 601.1, 1967, (HLM 0.10)].						
FS Date: 7/19/2016

Concrete headwall at LS toe.

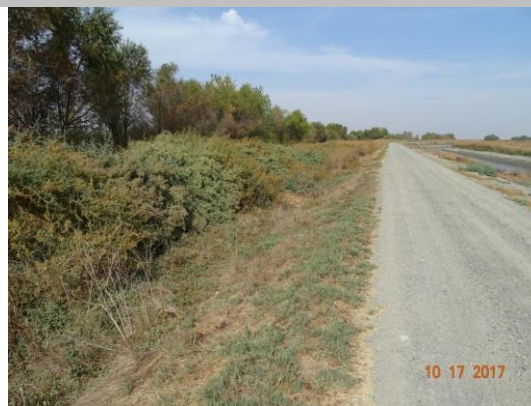
Photo 1 of 3 : SP\_2018\_NA0010\_138\_21\_20180307\_00018.jpg

LM Start	0.53	Rating **	U	Issue No.	21
LM End	0.85	Issue Type +	Ma	Location *	LS
Category	Earthen Levee			GPS Latitude/Longitude	
				Start	End
Item	Vegetation			37.213006 °	37.217593 °
				-120.698019 °	-120.697400 °
DWR ID	DWR_NA0010_22A_f_2014_21				
Comment Code					
V2 : Remove the wild growth other than native grasses from the levee slopes.					
Inspector Comment					
Dense vegetation on landside slope.

Looking northwest at the landside slope.

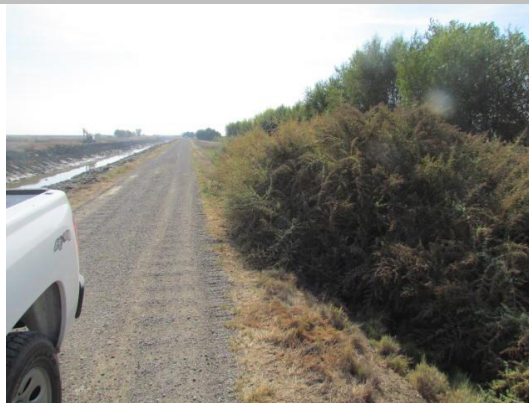
Photo 3 of 3 : SP\_2018\_NA0010\_138\_21\_20180307\_00020.jpg

Looking south at dense vegetation on landward slope. Spring 2015

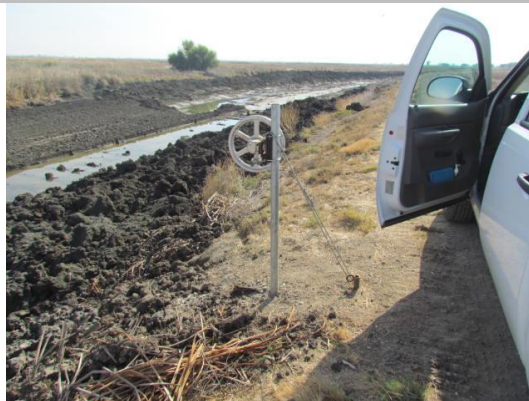
Photo 1 of 1 : SP\_2018\_NA0010\_138\_23\_20180307\_00021.jpg

LM Start	0.87	Rating **	M	Issue No.	23
LM End	0.87	Issue Type +	En	Location *	WS
Category	Earthen Levee			GPS Latitude/Longitude	
				Start	End
Item	Encroachments			37.217802 °	37.217802 °
				-120.697416 °	-120.697416 °
DWR ID	DWR_NA0010_22A_f _ 2014_23				
Comment Code					
SI : Sign					
Inspector Comment					
Pulley on waterside shouder without board permit.

Looking south at pulley on waterward shoulder.

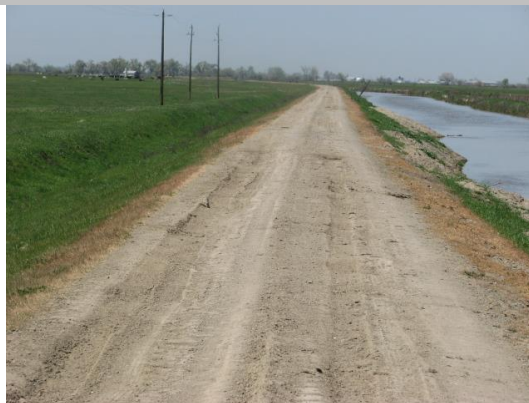
Photo 1 of 2 : SP\_2018\_NA0010\_138\_10\_20180411\_00035.jpg

LM Start	1.03	Rating **	M	Issue No.	10
LM End	5.09	Issue Type +	Ma	Location *	CR
Category	Earthen Levee			GPS Latitude/Longitude	
				Start	End
Item	Crown Surface / Depressions / Rutting			37.220040 °	37.267962 °
				-120.698181 °	-120.736909 °
DWR ID	DWR_NA0010_22A_s_2018_10				
Comment Code					
C2 : Repair depressions or ruts in the crown or slope.					
Inspector Comment					
Several pot holes and depressions along levee crown.

Looking upstream at rutting on levee crown within this section. (Spring 2018)

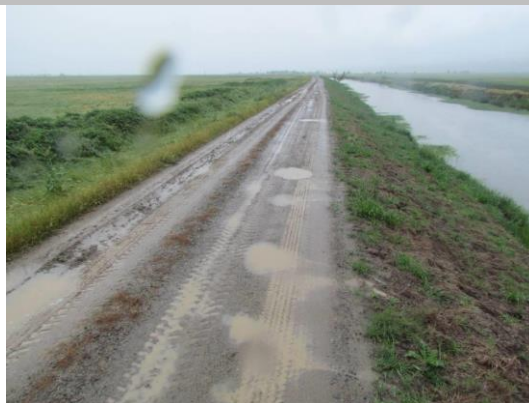
Photo 2 of 2 : SP\_2018\_NA0010\_138\_10\_20180307\_00011.jpg

Looking downstream at rutting and potholes on levee crown. (Fall 2017)

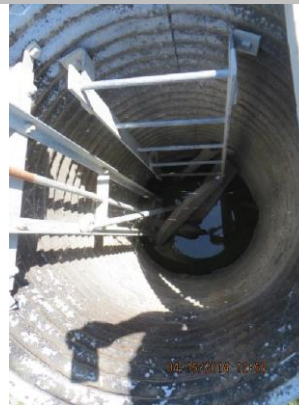
Photo 2 of 3 : UCIP\_SP\_2018\_33733\_61029.jpg

Inside CMP riser on WS shoulder.

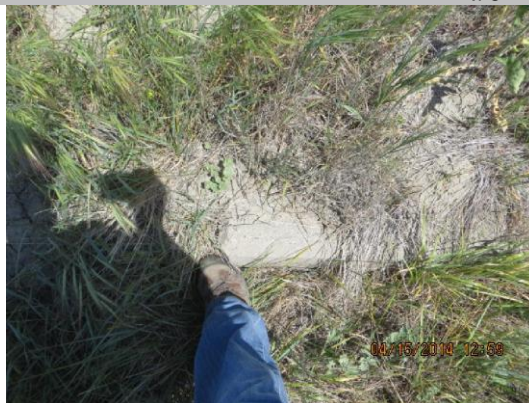
Photo 3 of 3 : UCIP\_SP\_2018\_33733\_61028.jpg

LM Start	1.57	Rating **	M	Issue No.	261 (cont)	
LM End	1.57	Issue Type +	En	Location *		
Category	Supplemental			GPS Latitude/Longitude		
				Start		End
Item	DWR UCIP Field Study			37.227588 °	37.227588 °	
				-120.700945 °	-120.700945 °	
DWR ID						
Comment Code						
Inspector Comment						
FS_ID:33733 DS_ID:19936 EP_NO: N/A Repair Type: Non-Urgent Crossing Status: Found UCIP Comments: Slide gate rusted and does not function. Headwall burried at LS toe. Pipe appears abandoned and if so should be done so properly. FIELD_STRUCT_DESC: 8-inch corrugated metal gravity irrigation pipe through the levee, 7 feet below the crown. Slide gate in a 36-inch corrugated metal pipe (CMP) riser on the waterside (WS) slope. Concrete headwall on the landside (LS) end. [Additional Reference(s): DWR Levee Log, 2002. USACE San Joaquin O&M Manual 601.1, 1967, (HLM 1.57)]. FS Date: 4/15/2014

Buried concrete headwall on LS toe.

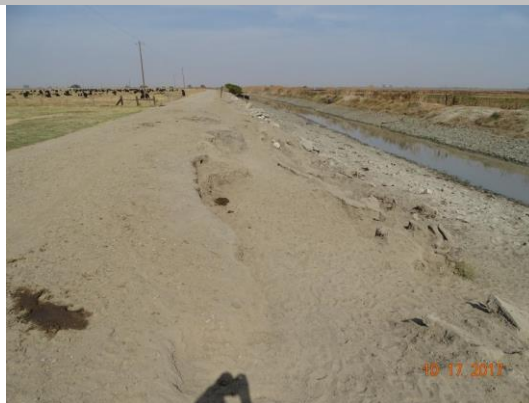
Photo 1 of 2 : SP\_2018\_NA0010\_138\_7\_20180307\_00005.jpg

LM Start	2.65	Rating **	U	Issue No.	7
LM End	2.65	Issue Type +	Ma	Location *	WS
Category	Earthen Levee			GPS Latitude/Longitude	
				Start	End
Item	Erosion / Bank Caving			37.242595 °	37.242595 °
				-120.706470 °	-120.706470 °
DWR ID	DWR_NA0010_22A_s_2017_7				
Comment Code					
E2 : Schedule repair of erosion site prior to the next inspection.					
Inspector Comment					
Erosion cutting into waterside shoulder.

Looking northwest at the waterside shoulder.

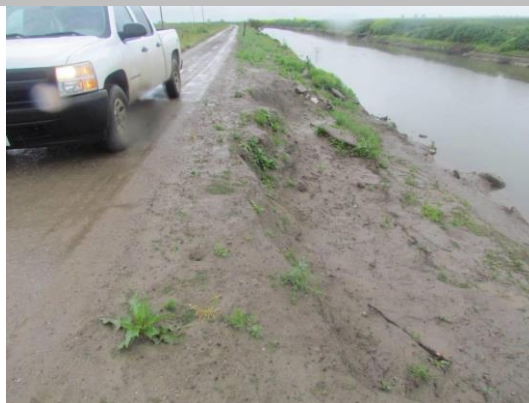
Photo 2 of 2 : SP\_2018\_NA0010\_138\_7\_20180307\_00006.jpg

Looking downstream at erosion on waterward shoulder and slope.

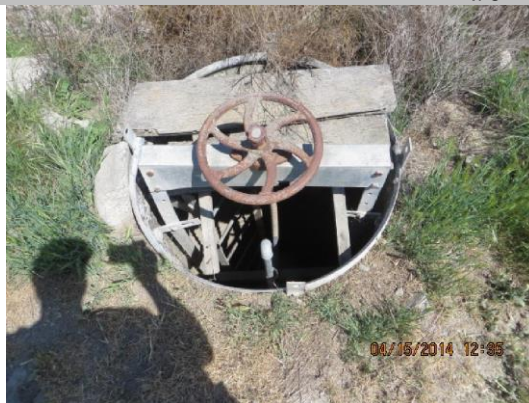
Photo 1 of 3 : UCIP\_SP\_2018\_33732\_61026.jpg

Comment Code					
Inspector Comment					
FS_ID:33732					
DS_ID:19937					
EP_NO: N/A					
Repair Type: Non-Urgent					
Crossing Status: Found					
UCIP Comments: Slide gate does not function and should be repaired.					
Headwall at LS toe not found.					
FIELD_STRUCT_DESC: 24-inch corrugated metal irrigation siphon pipe					
through the levee, 7.5 feet below the crown. Slide gate in a 36-inch					
corrugated metal pipe (CMP) riser on the waterside (WS) slope.					
Concrete U-shaped headwall on the landside (LS) end. [Additional					
Reference(s): DWR Levee Log, 2002. USACE San Joaquin O&M					
Manual 601.1, 1967, (HLM 2.72)].					
FS Date: 4/15/2014

Slidegate in CMP riser on WS shoulder. (Note: actuator does not work).

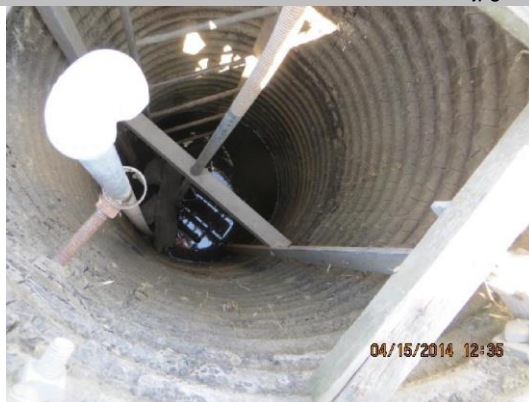
Photo 2 of 3 : UCIP\_SP\_2018\_33732\_61024.jpg

Inside CMP riser on WS shoulder.

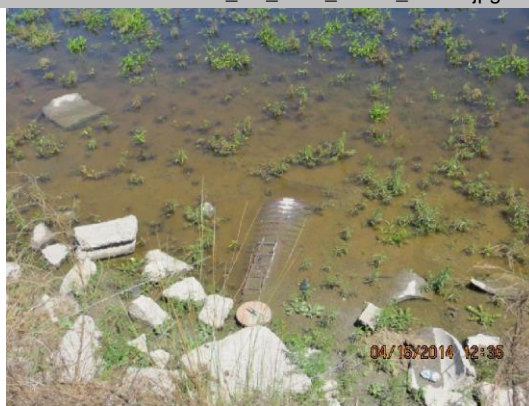
Photo 3 of 3 : UCIP\_SP\_2018\_33732\_61025.jpg

LM Start	2.71	Rating **	M	Issue No.	262 (cont)	
LM End	2.71	Issue Type +	En	Location *		
Category	Supplemental			GPS Latitude/Longitude		
				Start		End
Item	DWR UCIP Field Study			37.243501 °	37.243501 °	
				-120.706773 °	-120.706773 °	
DWR ID						
Comment Code						
Inspector Comment						
FS_ID:33732 DS_ID:19937 EP_NO: N/A Repair Type: Non-Urgent Crossing Status: Found UCIP Comments: Slide gate does not function and should be repaired. Headwall at LS toe not found. FIELD_STRUCT_DESC: 24-inch corrugated metal irrigation siphon pipe through the levee, 7.5 feet below the crown. Slide gate in a 36-inch corrugated metal pipe (CMP) riser on the waterside (WS) slope. Concrete U-shaped headwall on the landside (LS) end. [Additional Reference(s): DWR Levee Log, 2002. USACE San Joaquin O&M Manual 601.1, 1967, (HLM 2.72)]. FS Date: 4/15/2014

Pipe visible on WS toe.

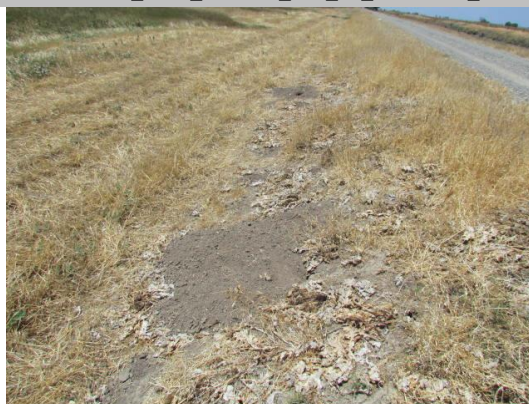
Photo 1 of 1 : SP\_2018\_NA0010\_138\_15\_20180307\_00014.jpg

LM Start	2.86	Rating **	M	Issue No.	15
LM End	3.05	Issue Type +	Ma	Location *	LS
Category	Earthen Levee			GPS Latitude/Longitude	
				Start	End
Item	Animal Control			37.245431 °	37.247343 °
				-120.707990 °	-120.710362 °
DWR ID	DWR_NA0010_22A_s_2014_15				
Comment Code					
A3 : No rodents visible, but rodent burrows visible; need to backfill and compact or grout burrows.					
Inspector Comment					
Several rodent holes on landside slope and toe.

Looking at several rodent holes on landward slope.

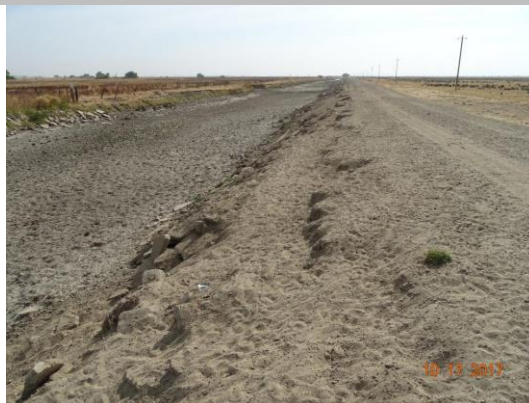
Photo 1 of 2 : SP\_2018\_NA0010\_138\_9\_20180307\_00009.jpg

LM Start	3.64	Rating **	U	Issue No.	9
LM End	3.69	Issue Type +	Ma	Location *	WS
Category	Earthen Levee			GPS Latitude/Longitude	
				Start	End
Item	Erosion / Bank Caving			37.253362 °	37.253862 °
				-120.717873 °	-120.718507 °
DWR ID	DWR_NA0010_22A_f_2016_9				
Comment Code					
E1 : Note and monitor erosion site.					
Inspector Comment					
Several erosions or levee damage caused by animal traffice within this section.

Looking southeast at the waterside slope.

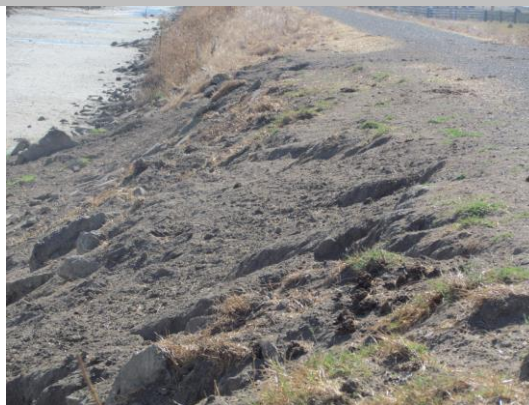
Photo 2 of 2 : SP\_2018\_NA0010\_138\_9\_20180307\_00010.jpg

Looking downstream at animal erosion on waterward slope.

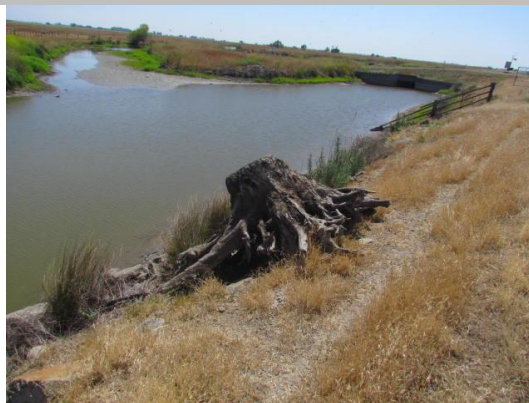
Photo 1 of 1 : SP\_2018\_NA0010\_138\_259\_20180307\_00022.jpg

LM Start	3.80	Rating **	M	Issue No.	259	
LM End	3.80	Issue Type +	Ma	Location *	WS	
Category	Earthen Levee			GPS Latitude/Longitude		
				Start		End
Item	Encroachments			37.255067 °		37.255067 °
				-120.719910 °		-120.719910 °
DWR ID	DWR_NA0010_22A_s_2015_259					
Comment Code						
TR : Tree or limb						
Inspector Comment						
Dead tree stump on waterside slope.

Looking east at dead stump on waterward slope.

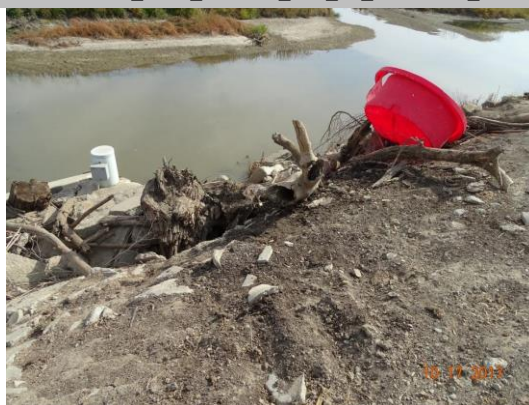
Photo 1 of 1 : SP\_2018\_NA0010\_138\_13\_20180307\_00012.jpg

LM Start	3.81	Rating **	M	Issue No.	13
LM End	3.81	Issue Type +	Ma	Location *	WS
Category	Earthen Levee			GPS Latitude/Longitude	
				Start	End
Item	Encroachments			37.255199°	37.255199°
				-120.720094°	-120.720094°
DWR ID	DWR_NA0010_22A_f_2017_13				
Comment Code					
TR : Tree or limb					
Inspector Comment

Looking northeast at the waterside slope.

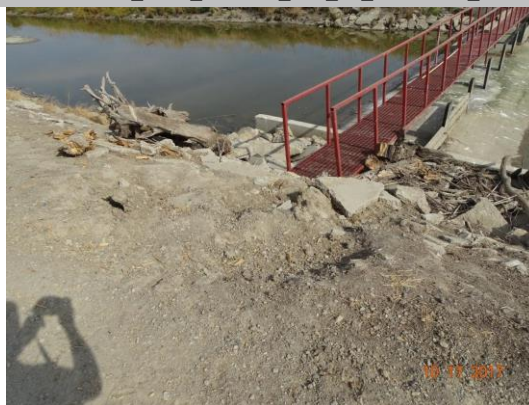
Photo 1 of 1 : SP\_2018\_NA0010\_138\_14\_20180307\_00013.jpg

LM Start	3.82	Rating **	A/W	Issue No.	14
LM End	3.82	Issue Type +	Ma	Location *	WS
Category	Earthen Levee			GPS Latitude/Longitude	
				Start	End
Item	Slope Stability			37.255239 °	37.255239 °
				-120.720142 °	-120.720142 °
DWR ID	DWR_NA0010_22A_f_2017_14				
Comment Code					
S1 : Repair slope instability.					
Inspector Comment

Looking northeast at the waterside slope.

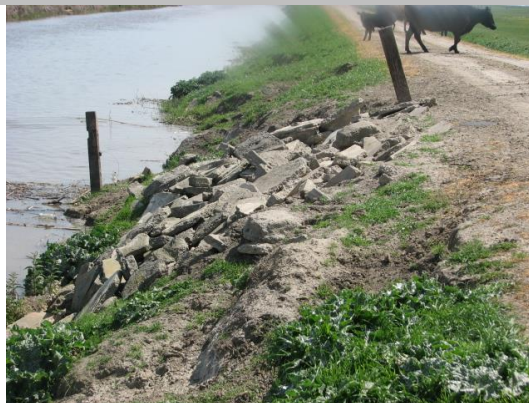
Photo 1 of 4 : SP\_2018\_NA0010\_138\_8\_20180411\_00036.jpg

LM Start	4.87	Rating **	A/W	Issue No.	8
LM End	4.87	Issue Type +	Ma	Location *	WS
Category	Earthen Levee			GPS Latitude/Longitude	
				Start	End
Item	Slope Stability			37.265813 °	37.265813 °
				-120.733748 °	-120.733748 °
DWR ID	DWR_NA0010_22A_f_2016_8				
Comment Code					
S1 : Repair slope instability.					
Inspector Comment					
Levee damage caused by animal traffic. Several site repaired with broken concrete. But other sites still need repairing.

Looking downstream at repaired site with concrete rubble on waterward slope and shoulder. (Spring 2018)

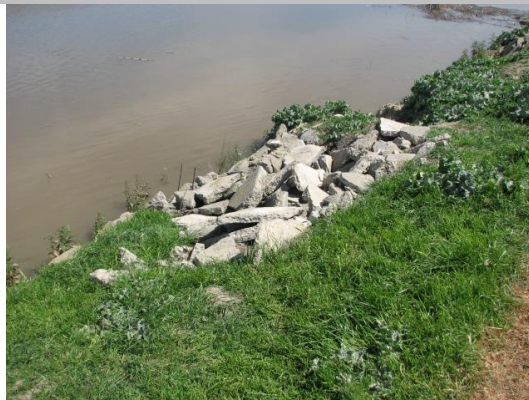
Photo 3 of 4 : SP\_2018\_NA0010\_138\_8\_20180411\_00037.jpg

Looking downstream at repaired site with concrete rubble on waterward slope. (Spring 2018)

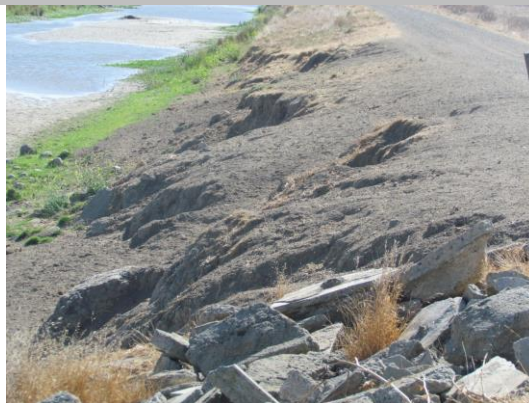
Photo 4 of 4 : SP\_2018\_NA0010\_138\_8\_20180307\_00007.jpg

LM Start	4.87	Rating **	A/W	Issue No.	8 (cont)	
LM End	4.87	Issue Type +	Ma	Location *	WS	
Category	Earthen Levee			GPS Latitude/Longitude		
				Start		End
Item	Slope Stability			37.265813 °		37.265813 °
				-120.733748 °		-120.733748 °
DWR ID	DWR_NA0010_22A_f_2016_8					
Comment Code						
S1 : Repair slope instability.						
Inspector Comment						
Levee damage caused by animal traffic. Several site repaired with broken concrete. But other sites still need repairing.

Looking downstream at animal erosion on waterward slope.

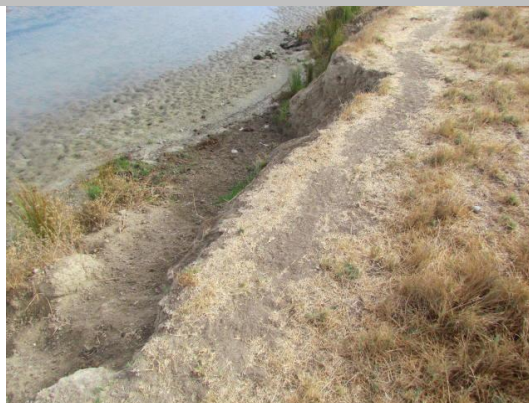
Photo 1 of 2 : SP\_2018\_NA0010\_138\_4\_20180307\_00001.jpg

LM Start	5.05	Rating **	M	Issue No.	4
LM End	5.05	Issue Type +	Ma	Location *	WS
Category	Earthen Levee			GPS Latitude/Longitude	
				Start	End
Item	Erosion / Bank Caving			37.267516 °	37.267516 °
				-120.736401 °	-120.736401 °
DWR ID	DWR_NA0010_22A_f_2013_4				
Comment Code					
E2 : Schedule repair of erosion site prior to the next inspection.					
Inspector Comment					
Erosion caused by animal traffic.

Looking southeast at livestock erosion on waterward toe.

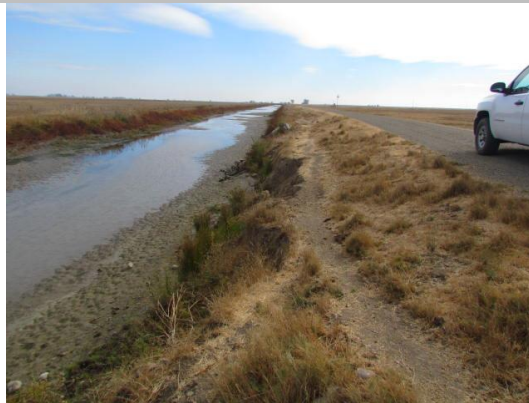
Photo 2 of 2 : SP\_2018\_NA0010\_138\_4\_20180307\_00002.jpg

Looking southeast at livestock erosion on waterward toe.

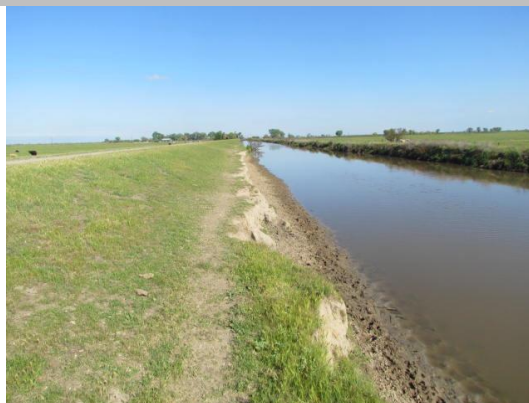
Photo 2 of 2 : SP\_2018\_NA0010\_138\_6\_20180307\_00004.jpg

Looking northwest at livestock erosion along waterside slope and toe.

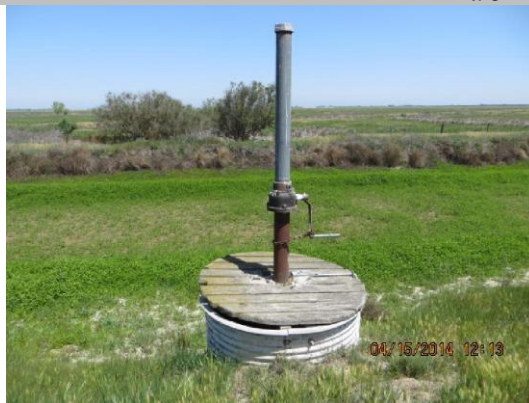
Photo 1 of 3 : UCIP\_SP\_2018\_39536\_61022.jpg

LM Start	5.48	Rating **	M	Issue No.	263
LM End	5.48	Issue Type +	En	Location *	
Category	Supplemental			GPS Latitude/Longitude	
				Start	End
Item	DWR UCIP Field Study			37.272079 °	37.272079 °
				-120.741575 °	-120.741575 °
DWR ID					
Comment Code					
Inspector Comment					
FS_ID:39536 DS_ID:19938 EP_NO: N/A Repair Type: Non-Urgent Crossing Status: Found UCIP Comments: Need to contact owner. Pipe silted in on LS toe. Appears abandoned and if so should be done so properly. FIELD_STRUCT_DESC: 48-inch corrugated metal irrigation siphon pipe through the levee, 10 feet below the crown. Slide gate in a 60-inch corrugated metal pipe (CMP) riser on the waterside (WS) slope. Concrete headwall on the landside (LS) end. WS end capped with a 0.25-inch steel plate. [Additional Reference(s): DWR Levee Log, 2002. USACE San Joaquin O&M Manual 601.1, 1967, (HLM 5.48)]. FS Date: 4/15/2014

Slidegate inside riser on WS shoulder.

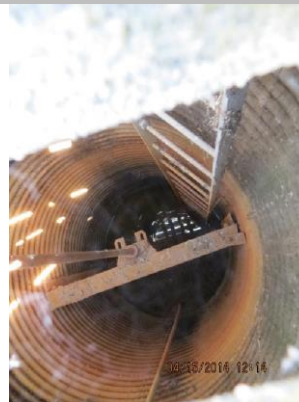
Photo 2 of 3 : UCIP\_SP\_2018\_39536\_61021.jpg

Inside riser on WS shoulder.

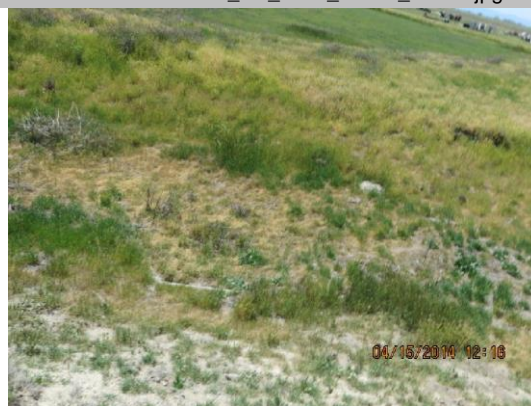
Photo 3 of 3 : UCIP\_SP\_2018\_39536\_61020.jpg

Comment Code						
Inspector Comment						
FS_ID:39536 DS_ID:19938 EP_NO: N/A Repair Type: Non-Urgent Crossing Status: Found UCIP Comments: Need to contact owner. Pipe silted in on LS toe. Appears abandoned and if so should be done so properly. FIELD_STRUCT_DESC: 48-inch corrugated metal irrigation siphon pipe through the levee, 10 feet below the crown. Slide gate in a 60-inch corrugated metal pipe (CMP) riser on the waterside (WS) slope. Concrete headwall on the landside (LS) end. WS end capped with a 0.25-inch steel plate. [Additional Reference(s): DWR Levee Log, 2002. USACE San Joaquin O&M Manual 601.1, 1967, (HLM 5.48)]. FS Date: 4/15/2014

Buried headwall on LS toe.

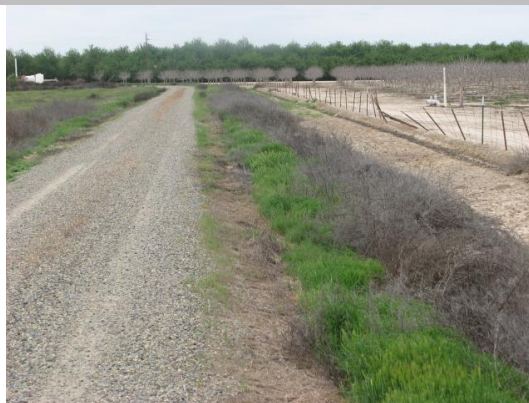
Photo 1 of 1 : SP\_2018\_NA0010\_139\_30\_20180411\_00055.jpg

LM Start	0.00	Rating **	M	Issue No.	30
LM End	10.24	Issue Type +	Ma	Location *	LS
Category	Earthen Levee			GPS Latitude/Longitude	
				Start	End
Item	Vegetation			36.774437 °	36.814780 °
				-120.283750 °	-120.168792 °
DWR ID	DWR_NA0010_23_s_2018_30				
Comment Code					
V1 : Control annual grass and weeds on the levee slopes and easements.					
Inspector Comment

Looking upstream at typical view of landward slope. (Spring 2018)

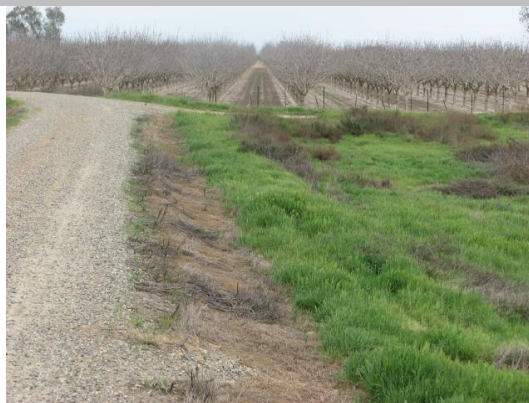
Photo 1 of 1 : SP\_2018\_NA0010\_139\_33\_20180411\_00056.jpg

LM Start	0.00	Rating **	M	Issue No.	33
LM End	10.24	Issue Type +	Ma	Location *	WS
Category	Earthen Levee			GPS Latitude/Longitude	
				Start	End
Item	Vegetation			36.774437 °	36.814783 °
				-120.283750 °	-120.168789 °
DWR ID	DWR_NA0010_23_s_2018_33				
Comment Code					
V1 : Control annual grass and weeds on the levee slopes and easements.					
Inspector Comment

Looking upstream at typical view of waterward slope. (Spring 2018)

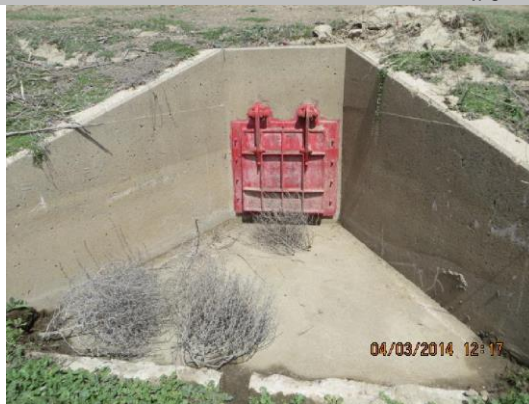
Photo 2 of 3 : UCIP\_SP\_2018\_39537\_59859.jpg

Flapgate on Concrete headwall at WS toe.

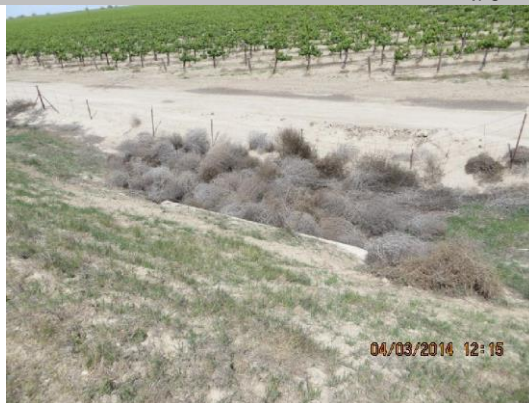
Photo 3 of 3 : UCIP\_SP\_2018\_39537\_59861.jpg

Comment Code						
Inspector Comment						
FS_ID:39537						
DS_ID:19945						
EP_NO: N/A						
Repair Type: Non-Urgent						
Crossing Status: Found						
UCIP Comments: Excessive vegetation at inlet--recommend clearing.						
FIELD_STRUCT_DESC: 30-inch by 30-inch square reinforced concrete box gravity drainage culvert through the levee, 13 feet below the crown. Flap gate on the waterside (WS) end. Concrete headwall on the landside (LS) end. Concrete U-shaped headwall on the WS end. (Plans to construct a new discharge structure and to rehabilitate one existing diversion structure to return intercepted seepage to the San Joaquin River authorized under Permit No. 13085, 1981 - Diener, Dry River Farms). [Additional Reference(s): DWR Levee Log, 2002. USACE San Joaquin O&M Manual 601.1, 1967, (HLM 0.21)].						
FS Date: 4/3/2014

Concrete headwall at LS toe. Excess vegetation buildup at inlet.

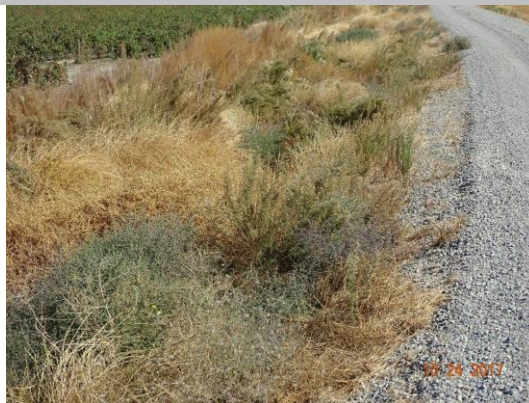
Photo 1 of 1 : SP\_2018\_NA0010\_139\_27\_20180307\_00023.jpg

LM Start	1.07	Rating **	U	Issue No.	27
LM End	1.15	Issue Type +	Ma	Location *	LS
Category	Earthen Levee			GPS Latitude/Longitude	
				Start	End
Item	Vegetation			36.772726 °	36.772884 °
				-120.267276 °	-120.265736 °
DWR ID	DWR_NA0010_23_f_2017_27				
Comment Code					
V2 : Remove the wild growth other than native grasses from the levee slopes.					
Inspector Comment					
LMA mowed at toe of levee, but due to dense vegetation unable to see landside slope with limited visibility of toe.

Looking east at landside slope.

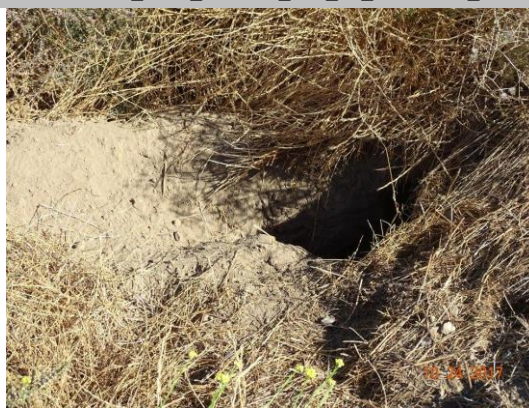
Photo 1 of 1 : SP\_2018\_NA0010\_139\_26\_20180307\_00022.jpg

LM Start	1.09	Rating **	U	Issue No.	26
LM End	1.09	Issue Type +	Ma	Location *	LS
Category	Earthen Levee			GPS Latitude/Longitude	
				Start	End
Item	Animal Control			36.772743 °	36.772743 °
				-120.266800 °	-120.266800 °
DWR ID	DWR_NA0010_23_f_2017_26				
Comment Code					
A3 : No rodents visible, but rodent burrows visible; need to backfill and compact or grout burrows.					
Inspector Comment					
Need to repair large rodent hole

Looking at the landside slope.

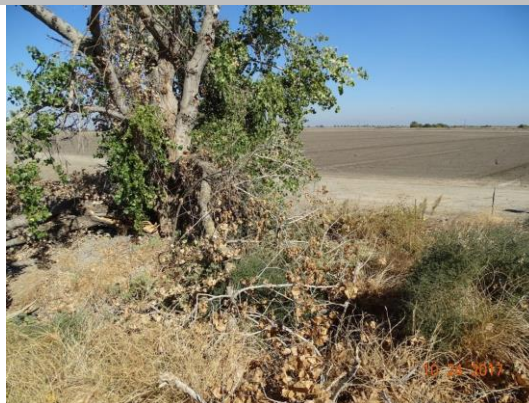
Photo 1 of 1 : SP\_2018\_NA0010\_139\_28\_20180307\_00024.jpg

LM Start	1.52	Rating **	M	Issue No.	28	
LM End	1.52	Issue Type +	Ma	Location *	LS	
Category	Earthen Levee			GPS Latitude/Longitude		
				Start		End
Item	Encroachments			36.772066 °		36.772066 °
				-120.259545 °		-120.259545 °
DWR ID	DWR_NA0010_23_f_2017_28					
Comment Code						
TR : Tree or limb						
Inspector Comment						
Downed tree limbs on landside slope.

Looking north at landside slope.

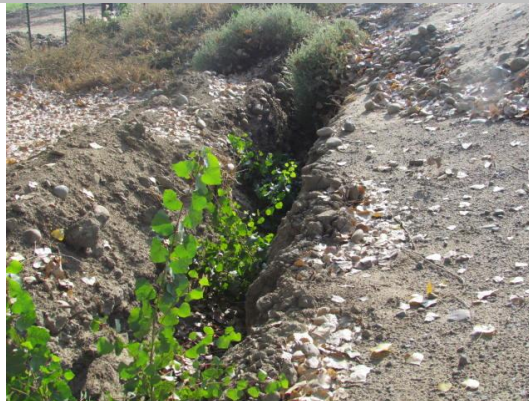
Photo 2 of 3 : SP\_2018\_NA0010\_139\_29\_20180307\_00026.jpg

Looking southeast at trench at landward toe.

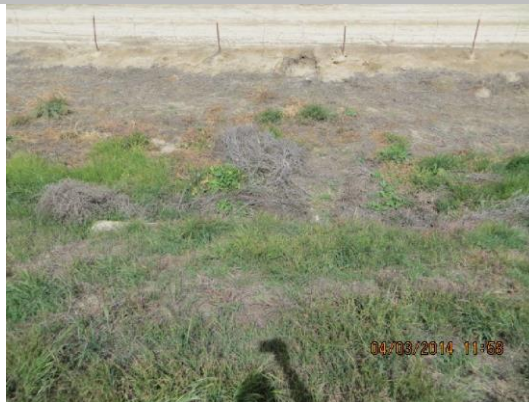
Photo 3 of 3 : UCIP\_SP\_2018\_39538\_59856.jpg

Concrete headwall on LS toe.

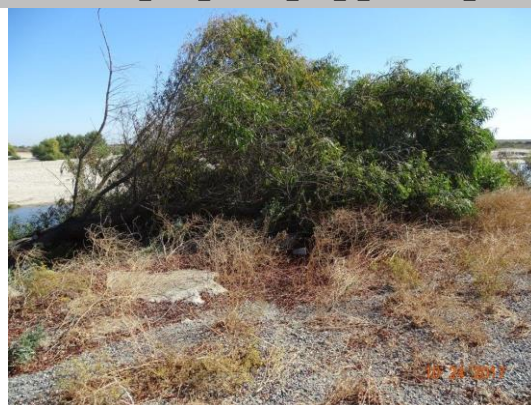
Photo 1 of 1 : SP\_2018\_NA0010\_139\_1\_20180307\_00001.jpg

LM Start	1.91	Rating **	U	Issue No.	1
LM End	1.91	Issue Type +	Ma	Location *	WS
Category	Earthen Levee			GPS Latitude/Longitude	
				Start	End
Item	Encroachments			36.772943 °	36.772943 °
				-120.253511 °	-120.253511 °
DWR ID	DWR_NA0010_23_s_2015_1				
Comment Code					
TR : Tree or limb					
Inspector Comment					
Downed tree on waterside slope.

Looking east at waterside slope.

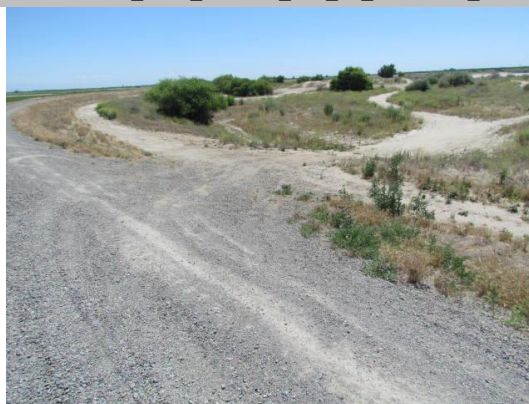
Photo 1 of 1 : SP\_2018\_NA0010\_139\_16\_20180307\_00017.jpg

LM Start	2.12	Rating **	M	Issue No.	16
LM End	2.12	Issue Type +	Ma	Location *	WS
Category	Earthen Levee			GPS Latitude/Longitude	
				Start	End
Item	Slope Stability			36.775507 °	36.775507 °
				-120.251672 °	-120.251670 °
DWR ID	DWR_NA0010_23_s_2013_16				
Comment Code					
S3 : Repair the levee slope damaged by vehicle traffic and prevent access where possible.					
Inspector Comment					
Several damaged sites within this reach. Damage caused by vehicle traffic. At. LM. 2.12, 2.21, 2.37, 2.41, & 2.47

Looking west at one of several slope damaged cause by vehicle traffice.

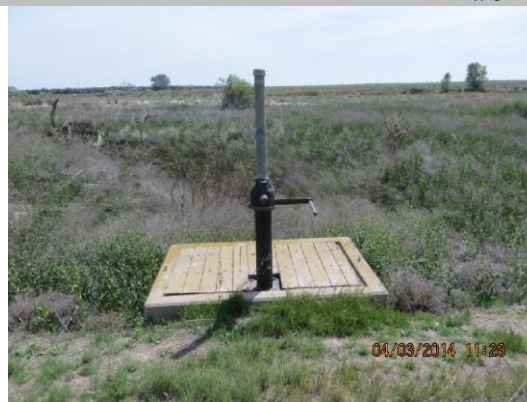
Photo 1 of 3 : UCIP\_SP\_2018\_39540\_59848.jpg

LM Start	4.85	Rating **	M	Issue No.	42
LM End	4.85	Issue Type +	En	Location *	
Category	Supplemental			GPS Latitude/Longitude	
				Start	End
Item	DWR UCIP Field Study			36.789550 °	36.789550 °
				-120.220367 °	-120.220367 °
DWR ID					
Comment Code					
Inspector Comment					
FS_ID:39540 DS_ID:19953 EP_NO: N/A Repair Type: Non-Urgent Crossing Status: Found UCIP Comments: Heavy vegetation at inlet and outlet--recommend clearing. FIELD_STRUCT_DESC: 30-inch by 30-inch square reinforced concrete box gravity irrigation culvert through the levee, 10.7 feet below the crown. 4.5-foot by 7-foot concrete riser with slide gate on the waterside (WS) slope. Concrete U-shaped headwall on each end. 15-foot-long cobble revetted inlet channel. [Additional Reference(s): DWR Levee Log, 2002]. FS Date: 4/3/2014

Slide gate in concrete riser on WS shoulder.

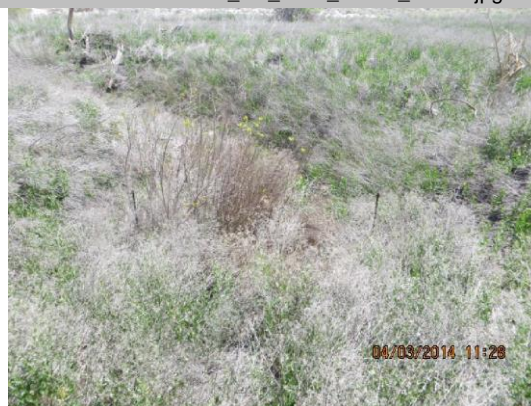
Photo 2 of 3 : UCIP\_SP\_2018\_39540\_59847.jpg

Heavy vegetation in outlet/channel on WS toe.

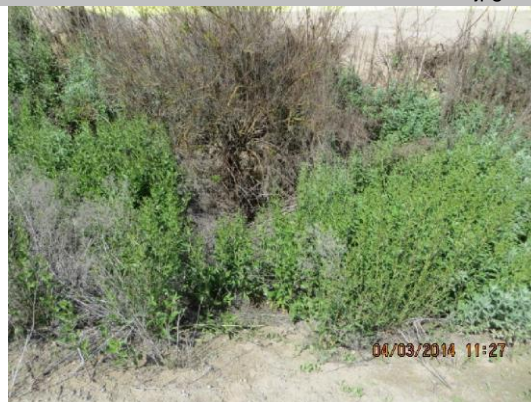
Photo 3 of 3 : UCIP\_SP\_2018\_39540\_59849.jpg

Heavy vegetation at concrete inlet on LS toe.

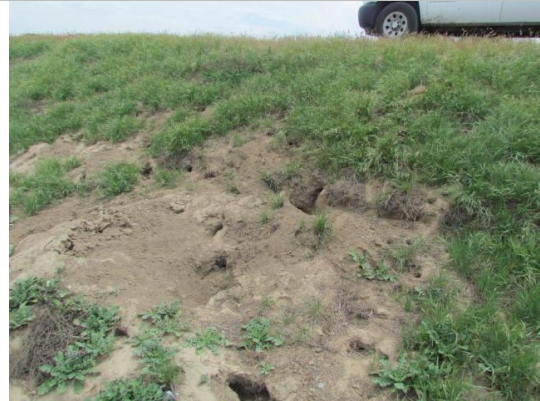
Photo 1 of 1 : SP\_2018\_NA0010\_139\_5\_20180307\_00006.jpg

LM Start	5.68	Rating **	U	Issue No.	5
LM End	5.68	Issue Type +	Ma	Location *	LS
Category	Earthen Levee			GPS Latitude/Longitude	
				Start	End
Item	Animal Control			36.791981 °	36.791981 °
				-120.206274 °	-120.206274 °
DWR ID	DWR_NA0010_23_s_2012_5				
Comment Code					
A1 : Exterminate rodents and backfill and compact or grout burrows.					
Inspector Comment					
Several large rodent holes in this area.

Looking at several rodent holes on landside slope.

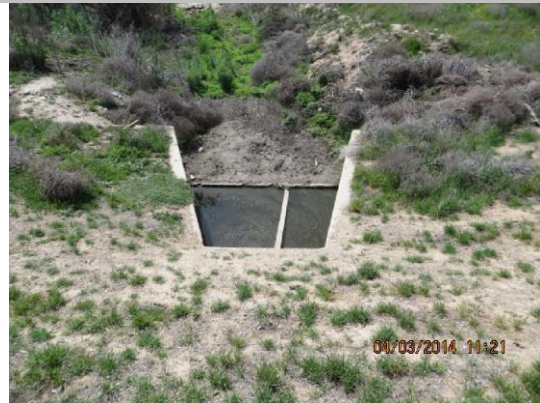
Photo 1 of 3 : UCIP\_SP\_2018\_39542\_59830.jpg

Comment Code						
Inspector Comment						
FS_ID:39542						
DS_ID:19954						
EP_NO: N/A						
Repair Type: Non-Urgent						
Crossing Status: Found						
UCIP Comments: Dense vegetation limits the inspector's visibility to identify signs of pipe failure (leaks) along the landward slope.						
Recommend removing vegetation along pipe alignment to conduct proper inspection of structure.						
FIELD_STRUCT_DESC: 36-inch by 36-inch square reinforced concrete box gravity drainage culvert through the levee, 9 feet below the crown.						
Flap gate on the waterside (WS) end. Concrete U-shaped headwall on each end. 5-foot-long cobble revetted outlet channel. [Additional						
Reference(s): DWR Levee Log, 2002. USACE San Joaquin O&M Manual 601.1, 1967, (HLM 5.71)].						
FS Date: 4/3/2014

Concrete headwall on WS toe.
