**Flood Control Project Maintenance  
Levee Inspections**  
**LMA District Cover Sheet**  
**Spring 2018 Levee Inspection Results**

**Lower San Joaquin Levee District**

**Spring 2018 Levee Inspection Results**

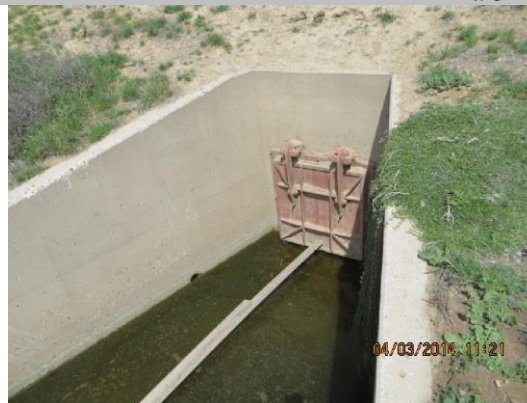
Photo 2 of 3 : UCIP\_SP\_2018\_39542\_59829.jpg

Flapgate on Concrete headwall on WS toe.

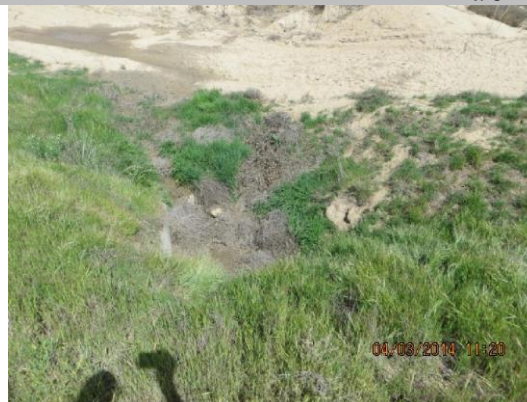
Photo 3 of 3 : UCIP\_SP\_2018\_39542\_59831.jpg

Concrete headwall at LS toe.

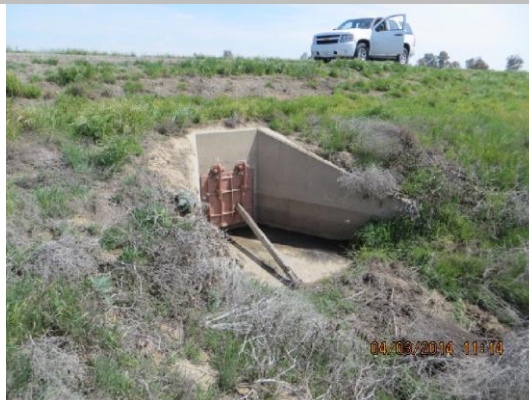
Photo 2 of 3 : UCIP\_SP\_2018\_39543\_59828.jpg

Flapgate on Concrete headwall at WS toe.

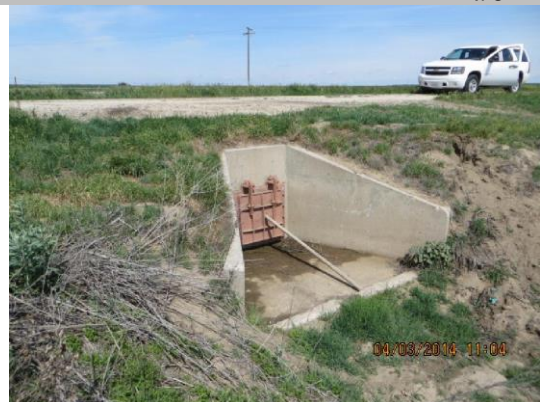
Photo 1 of 3 : UCIP\_SP\_2018\_39544\_59823.jpg

Comment Code					
Inspector Comment					
FS_ID:39544					
DS_ID:19940					
EP_NO: N/A					
Repair Type: Non-Urgent					
Crossing Status: Found					
UCIP Comments: Some sediment buildup at inlet at LS toe. Also dense vegetation limits the inspector's visibility to identify signs of pipe failure (leaks) along the landward slope. Recommend removing vegetation along pipe alignment to conduct proper inspection of structure.					
FIELD_STRUCT_DESC: 30-inch by 30-inch square reinforced concrete box gravity drainage culvert through the levee, 5.2 feet below the crown. Flap gate on the waterside (WS) end. Concrete headwall on the landside (LS) end. Concrete U-shaped headwall on the WS end.					
[Additional Reference(s): DWR Levee Log, 2002. USACE San Joaquin O&M Manual 601.1, 1967, (HLM 8.33)].					
FS Date: 4/3/2014

Flapgate on WS toe.

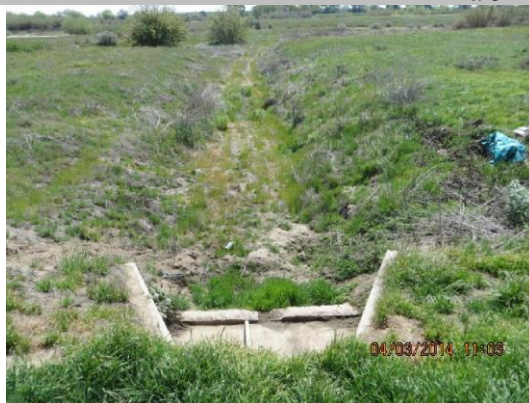
Photo 2 of 3 : UCIP\_SP\_2018\_39544\_59821.jpg

concrete headwall at drainage ditch on WS toe.

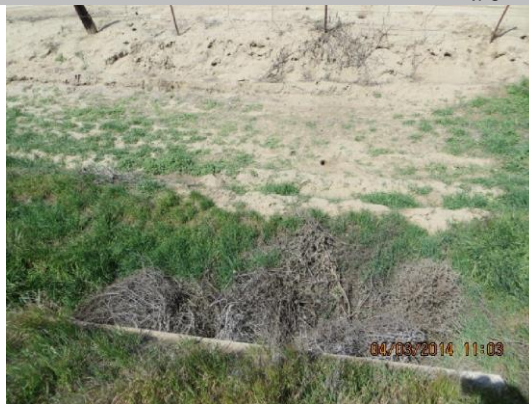
Photo 3 of 3 : UCIP\_SP\_2018\_39544\_59822.jpg

Concrete headwall on LS toe.

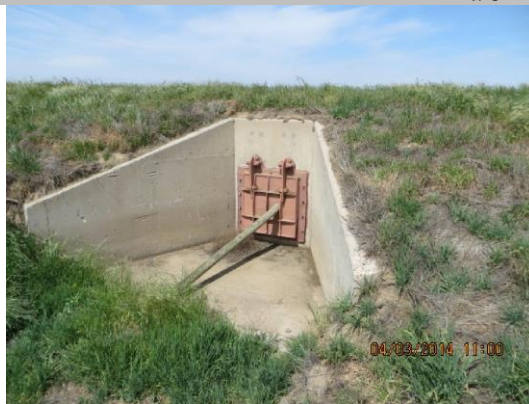
Photo 2 of 3 : UCIP\_SP\_2018\_39545\_59819.jpg

Flapgate on Concrete headwall at WS toe.

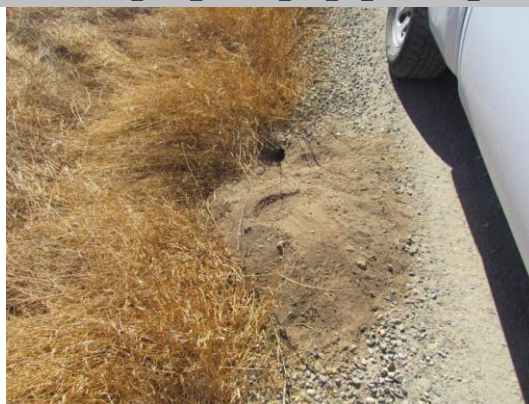
Photo 1 of 1 : SP\_2018\_NA0010\_139\_25\_20180307\_00021.jpg

LM Start	8.97	Rating **	U	Issue No.	25
LM End	8.97	Issue Type +	Ma	Location *	WS
Category	Earthen Levee			GPS Latitude/Longitude	
				Start	End
Item	Animal Control			36.799606 °	36.799606 °
				-120.175395 °	-120.175395 °
DWR ID	DWR_NA0010_23_f_2016_25				
Comment Code					
A3 : No rodents visible, but rodent burrows visible; need to backfill and compact or grout burrows.					
Inspector Comment					
Rodent holes on waterside shoulder.

Looking at typical view of rodent hole on waterward shoulder.

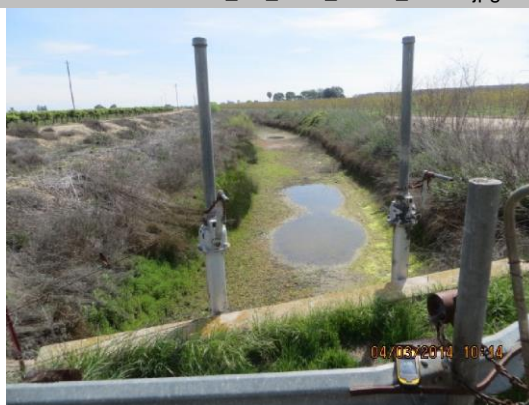
Photo 1 of 3 : UCIP\_SP\_2018\_49971\_59810.jpg

Comment Code					
Inspector Comment					
FS_ID:49971 DS_ID:19943 EP_NO: N/A Repair Type: Urgent Crossing Status: Found UCIP Comments: 7/20/2016 No change--same as previous inspection. (DWR UCIP - omagana)4/03/2014 Slide gate not functional. Slide gate channels heavily corroded (exfoliated) and likely impact functionality/structural integrity of gate. (DWR UCIP - omagana) FIELD_STRUCT_DESC: [Gravelly Ford Canal Irrigation Structure] 1 of 2: 48-inch by 63-inch reinforced concrete box gravity irrigation culvert through the levee, 10 feet below the crown. Concrete U-shaped headwall on each end. Gear pedestal slide gate with wall bracket on the waterside (WS) headwall. 10-foot-long cobble revetted outlet channel. Guardrail on each shoulder. Slide gates on the WS. [Additional Reference(s): DWR Levee Log, 2002. USACE San Joaquin O&M Manual 601.1, 1967, (HLM 9.76)]. FS Date: 7/20/2016

Slide gate actuator visible on WS shoulder with concrete headwall.

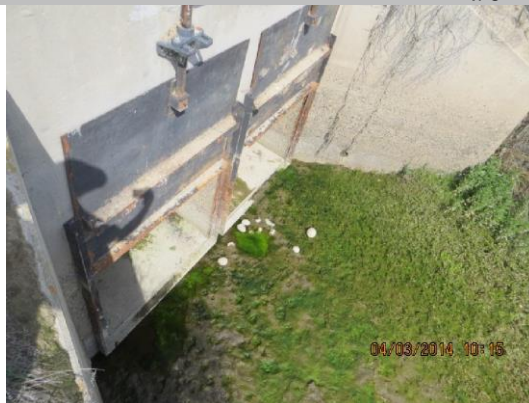
Photo 2 of 3 : UCIP\_SP\_2018\_49971\_59809.jpg

Slide gate on concrete headwall at WS toe.

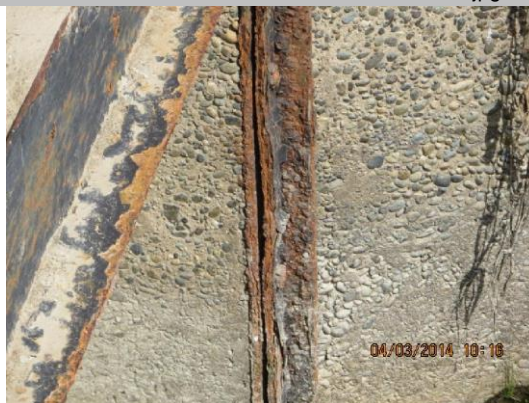
Photo 3 of 3 : UCIP\_SP\_2018\_49971\_59808.jpg

Heavy corrosion in slide gate tracks on WS toe.

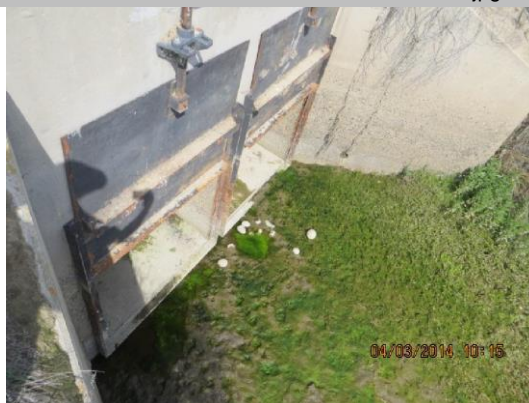
Photo 2 of 3 : UCIP\_SP\_2018\_49972\_59801.jpg

Comment Code						
Inspector Comment						
FS_ID:49972 DS_ID:19980 EP_NO: N/A Repair Type: Urgent Crossing Status: Found UCIP Comments: 7/20/2016 No change--same as previous inspection. (DWR UCIP - omagana)4/03/2014 Slide gate not functional. Slide gate channels heavily corroded (exfoliated) and likely impact functionality/structural integrity of gate. (DWR UCIP - omagana) FIELD_STRUCT_DESC: [Gravelly Ford Canal Irrigation Structure] 2 of 2: 48-inch by 63-inch reinforced concrete box gravity irrigation culvert through the levee, 10 feet below the crown. Concrete U-shaped headwall on each end. Gear pedestal slide gate with wall bracket on the waterside (WS) headwall. 10-foot-long cobble revetted outlet channel. Guardrail on each shoulder. [Additional Reference(s): DWR Levee Log, 2002]. FS Date: 7/20/2016

Slide gates on WS toe.

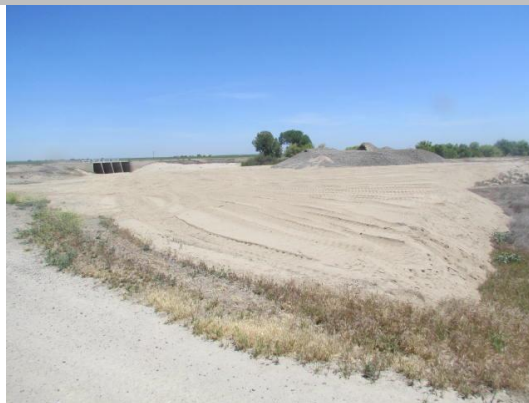
Photo 1 of 2 : SP\_2018\_NA0010\_140\_47\_20180307\_00009.jpg

LM Start	<b>0.06</b>	Rating **	M	Issue No.	<b>47</b>
LM End	<b>0.06</b>	Issue Type +	En	Location *	WS
Category	Earthen Levee		GPS Latitude/Longitude		
			Start	End	
Item	Encroachments		36.772328 °	36.772328 °	
			-120.285117 °	-120.285117 °	
DWR ID	DWR_NA0010_24_s_2014_47				
Comment Code					
MA : Material					
Inspector Comment					
District constructed a berm on waterside slope. Berm is being used for staging of earthen material.

Looking northeast at berm on waterward slope.

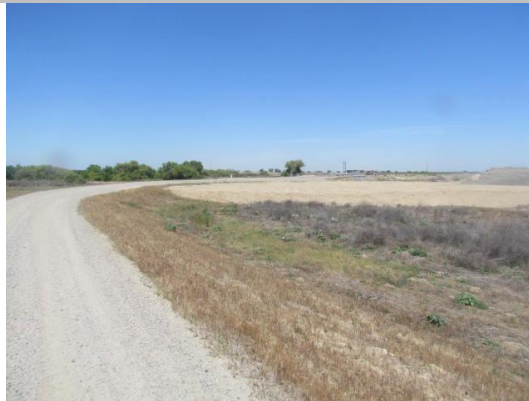
Photo 2 of 2 : SP\_2018\_NA0010\_140\_47\_20180307\_00010.jpg

LM Start	0.06	Rating **	M	Issue No.	47 (cont)
LM End	0.06	Issue Type +	En	Location *	WS
Category	Earthen Levee			GPS Latitude/Longitude	
				Start	End
Item	Encroachments			36.772328 °	36.772328 °
				-120.285117 °	-120.285117 °
DWR ID	DWR_NA0010_24_s_2014_47				
Comment Code					
MA : Material					
Inspector Comment					
District constructed a berm on waterside slope. Berm is being used for staging of earthen material.

Looking north at berm on waterward slope.

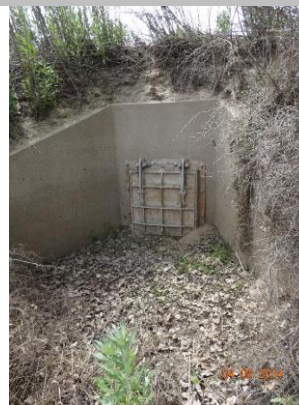
Photo 2 of 3 : UCIP\_SP\_2018\_33264\_60057.jpg

Square gate visible on waterward side.

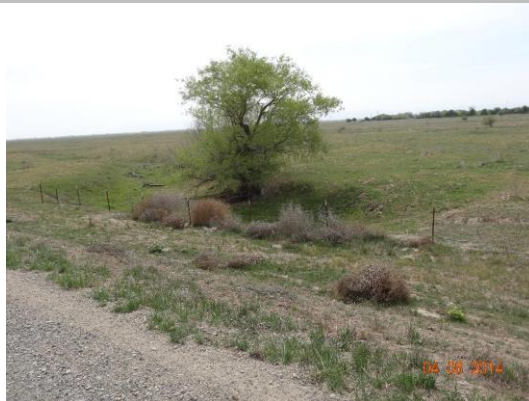
Photo 3 of 3 : UCIP\_SP\_2018\_33264\_60058.jpg

LM Start	0.50	Rating **	M	Issue No.	267 (cont)	
LM End	0.50	Issue Type +	En	Location *		
Category	Supplemental			GPS Latitude/Longitude		
				Start	End	
Item	DWR UCIP Field Study			36.766872 °	36.766872 °	
				-120.283212 °	-120.283212 °	
DWR ID						
Comment Code						
Inspector Comment						
FS_ID:33264 DS_ID:19955 EP_NO: N/A Repair Type: Non-Urgent Crossing Status: Found UCIP Comments: No access available to confirm condition of landward side headwall. Recommend clearing debris along fence. Surface erosion near concrete headwall on landward side was present. FIELD_STRUCT_DESC: 30-inch by 30-inch square reinforced concrete box gravity drainage culvert through the levee, 13.5 feet below the crown. Flap gate on the waterside (WS) end. Concrete headwall on each end. [Additional Reference(s): DWR Levee Log, 2002]. FS Date: 4/8/2014

View of landward side.

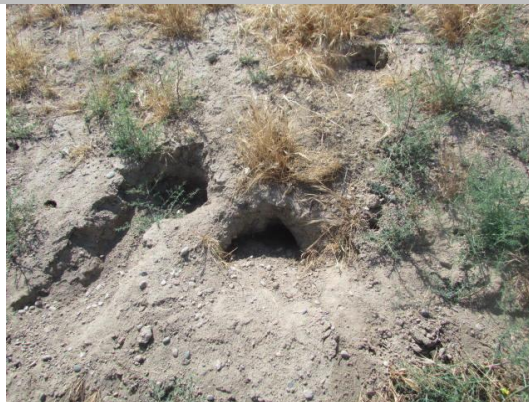
Photo 1 of 1 : SP\_2018\_NA0010\_140\_6\_20180307\_00003.jpg

LM Start	0.82	Rating **	M	Issue No.	6
LM End	0.84	Issue Type +	Ma	Location *	LS
Category	Earthen Levee			GPS Latitude/Longitude	
				Start	End
Item	Animal Control			36.766775 °	36.766962 °
				-120.278757 °	-120.278602 °
DWR ID	DWR_NA0010_24_s_2013_6				
Comment Code					
A1 : Exterminate rodents and backfill and compact or grout burrows.					
Inspector Comment					
Several rodent holes identified within this section.

Looking at several rodent holes on landward slope.

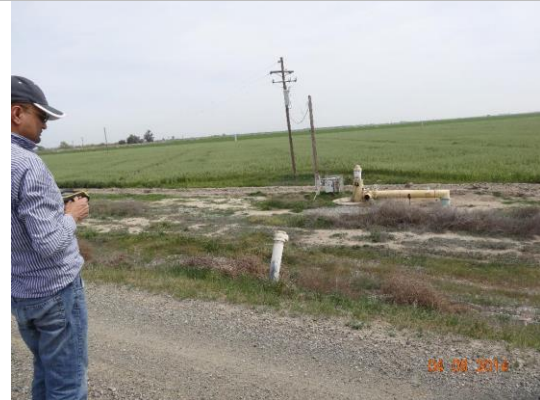
Photo 1 of 2 : UCIP\_SP\_2018\_33265\_60065.jpg

Item	DWR UCIP Field Study		36.769574 °	36.769574 °	
			-120.276253 °	-120.276253 °	
DWR ID					
Comment Code					
Inspector Comment					
FS_ID:33265					
DS_ID:19961					
EP_NO: 13735					
Repair Type: Non-Urgent					
Crossing Status: Found					
UCIP Comments: Unable to determine status of crossing. Need to contact owner to determine status of crossing.					
FIELD_STRUCT_DESC: 24-inch coated steel drainage discharge pipe through the levee, 2 feet below the crown. Crown roadway has been padded 1 foot. Steel cutoff wall around the pipe at the centerline of the levee. Pump on the landside (LS). Siphon breaker on the apex of the pipe on the LS shoulder. Galvanized siphon vent pipe on the LS shoulder. (Plans to install two 24-inch steel discharge pipelines through the levee to dispose of seepage water collected in farm sumps Nos. 8 and 12 authorized under Permit No. 13735, 1983 - Rio Seco Farm).					
[Additional Reference(s): DWR Levee Log, 2002].

View of landward side.

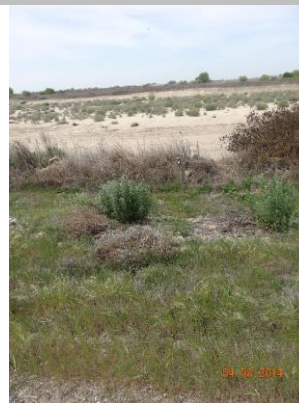
Photo 2 of 2 : UCIP\_SP\_2018\_33265\_60064.jpg

Comment Code						
Inspector Comment						
FS_ID:33265 DS_ID:19961 EP_NO: 13735 Repair Type: Non-Urgent Crossing Status: Found UCIP Comments: Unable to determine status of crossing. Need to contact owner to determine status of crossing. FIELD_STRUCT_DESC: 24-inch coated steel drainage discharge pipe through the levee, 2 feet below the crown. Crown roadway has been padded 1 foot. Steel cutoff wall around the pipe at the centerline of the levee. Pump on the landside (LS). Siphon breaker on the apex of the pipe on the LS shoulder. Galvanized siphon vent pipe on the LS shoulder. (Plans to install two 24-inch steel discharge pipelines through the levee to dispose of seepage water collected in farm sumps Nos. 8 and 12 authorized under Permit No. 13735, 1983 - Rio Seco Farm). [Additional Reference(s): DWR Levee Log, 2002]. FS Date: 4/8/2014

View of waterward side.

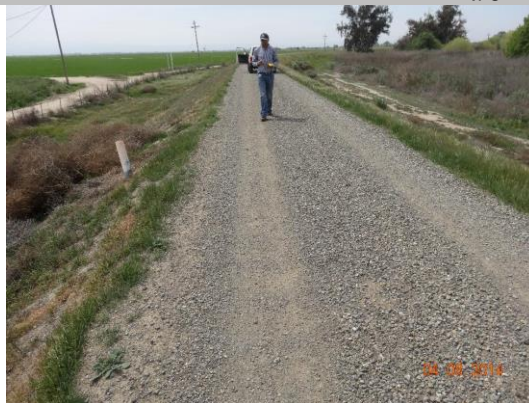
Photo 1 of 3 : UCIP\_SP\_2018\_33266\_60069.jpg

Comment Code					
Inspector Comment					
FS_ID:33266 DS_ID:19962 EP_NO: 13085 Repair Type: Non-Urgent Crossing Status: Indicator Found UCIP Comments: Need to contact owner to determine status. FIELD_STRUCT_DESC: 20-inch coated steel gravity drainage pipe through the levee, 2 feet below the crown. Pipe encased in concrete through the levee crown. Steel cutoff wall around the pipe at each shoulder. Siphon breaker installed on the apex of the pipe on the landside (LS) shoulder. Vent pipe on LS shoulder. Rock riprap on the waterside (WS) slope. (Plans to construct a new discharge structure and to rehabilitate one existing diversion structure to return intercepted seepage to the San Joaquin River authorized under Permit No. 13085, 1981 - Diener, Dry River Farms). [Additional Reference(s): DWR Levee Log, 2002]. FS Date: 4/8/2014

Overview of levee crown at crossing.

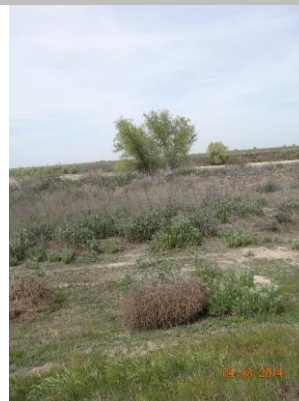
Photo 2 of 3 : UCIP\_SP\_2018\_33266\_60070.jpg

View of waterward side.

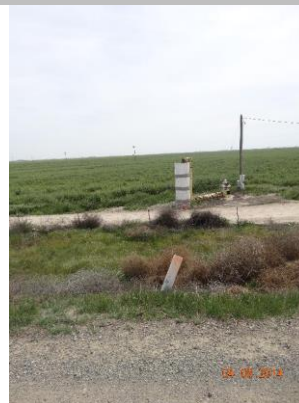
Photo 3 of 3 : UCIP\_SP\_2018\_33266\_60071.jpg

Comment Code						
Inspector Comment						
FS_ID:33266 DS_ID:19962 EP_NO: 13085 Repair Type: Non-Urgent Crossing Status: Indicator Found UCIP Comments: Need to contact owner to determine status. FIELD_STRUCT_DESC: 20-inch coated steel gravity drainage pipe through the levee, 2 feet below the crown. Pipe encased in concrete through the levee crown. Steel cutoff wall around the pipe at each shoulder. Siphon breaker installed on the apex of the pipe on the landside (LS) shoulder. Vent pipe on LS shoulder. Rock riprap on the waterside (WS) slope. (Plans to construct a new discharge structure and to rehabilitate one existing diversion structure to return intercepted seepage to the San Joaquin River authorized under Permit No. 13085, 1981 - Diener, Dry River Farms). [Additional Reference(s): DWR Levee Log, 2002]. FS Date: 4/8/2014

View of landward side.

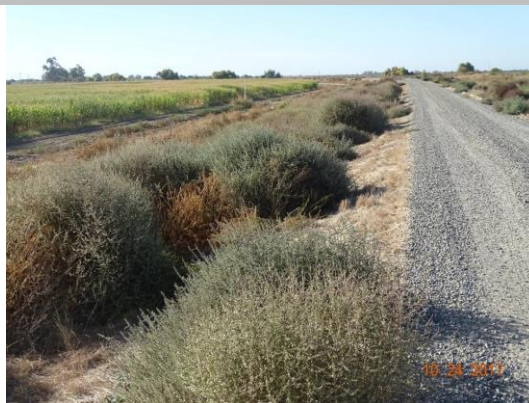
Photo 1 of 1 : SP\_2018\_NA0010\_140\_19\_20180307\_00008.jpg

LM Start	2.07	Rating **	U	Issue No.	19
LM End	2.13	Issue Type +	Ma	Location *	LS
Category	Earthen Levee			GPS Latitude/Longitude	
				Start	End
Item	Vegetation			36.770778 °	36.770293 °
				-120.260848 °	-120.259840 °
DWR ID	DWR_NA0010_24_f_2017_19				
Comment Code					
V2 : Remove the wild growth other than native grasses from the levee slopes.					
Inspector Comment					
LMA mowed landside toe, however dense vegetation on slope limits visibility.

Looking northwest at landside slope.

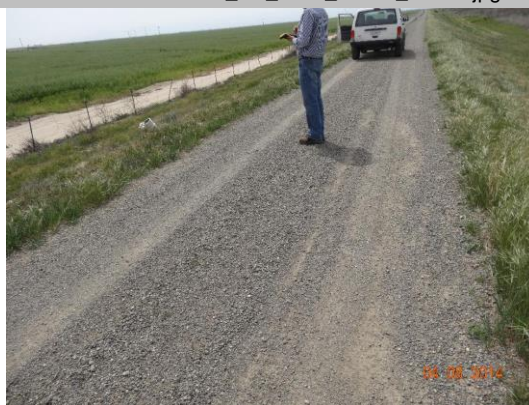
Photo 1 of 3 : UCIP\_SP\_2018\_33267\_60075.jpg

Comment Code						
Inspector Comment						
FS_ID:33267 DS_ID:19963 EP_NO: 13735 Repair Type: Non-Urgent Crossing Status: Found UCIP Comments: Unable to confirm status of crossing. FIELD_STRUCT_DESC: 24-inch coated steel drainage discharge pipe through the levee, 2 feet below the crown. Crown roadway has been padded 1 foot. Steel cutoff wall around the pipe at the centerline of the levee. Pump on the landside (LS). Siphon breaker on the apex of the pipe on the LS shoulder. Galvanized siphon vent pipe on the LS shoulder. (Plans to install two 24-inch steel discharge pipelines through the levee to dispose of seepage water collected in farm sumps Nos. 8 and 12 authorized under Permit No. 13735, 1983 - Rio Seco Farm). [Additional Reference(s): DWR Levee Log, 2002]. FS Date: 4/8/2014

Overview of levee crown at crossing.

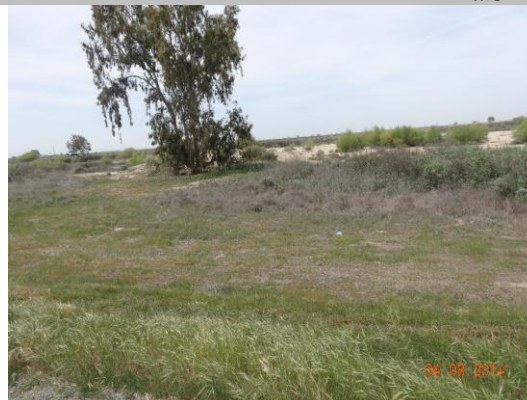
Photo 2 of 3 : UCIP\_SP\_2018\_33267\_60076.jpg

Comment Code						
Inspector Comment						
FS_ID:33267 DS_ID:19963 EP_NO: 13735 Repair Type: Non-Urgent Crossing Status: Found UCIP Comments: Unable to confirm status of crossing. FIELD_STRUCT_DESC: 24-inch coated steel drainage discharge pipe through the levee, 2 feet below the crown. Crown roadway has been padded 1 foot. Steel cutoff wall around the pipe at the centerline of the levee. Pump on the landside (LS). Siphon breaker on the apex of the pipe on the LS shoulder. Galvanized siphon vent pipe on the LS shoulder. (Plans to install two 24-inch steel discharge pipelines through the levee to dispose of seepage water collected in farm sumps Nos. 8 and 12 authorized under Permit No. 13735, 1983 - Rio Seco Farm). [Additional Reference(s): DWR Levee Log, 2002]. FS Date: 4/8/2014

View of waterward side.

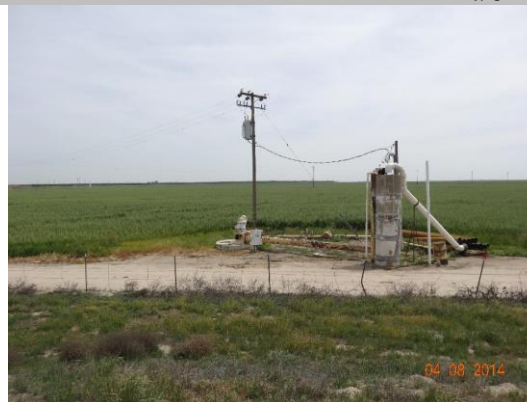
Photo 3 of 3 : UCIP\_SP\_2018\_33267\_60077.jpg

View of landward side.

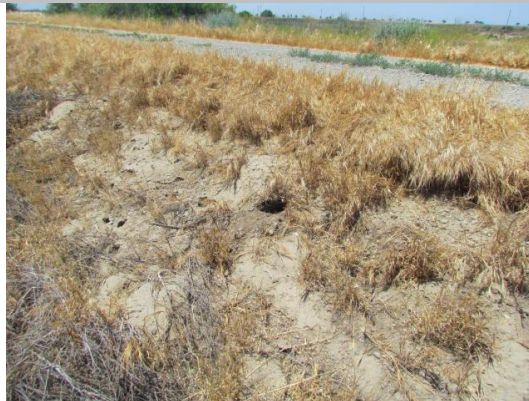
Photo 1 of 1 : SP\_2018\_NA0010\_140\_7\_20180307\_00004.jpg

LM Start	3.46	Rating **	M	Issue No.	7
LM End	3.46	Issue Type +	Ma	Location *	LS
Category	Earthen Levee			GPS Latitude/Longitude	
				Start	End
Item	Animal Control			36.769345 °	36.769345 °
				-120.238370 °	-120.238370 °
DWR ID	DWR_NA0010_24_s_2012_7				
Comment Code					
A3 : No rodents visible, but rodent burrows visible; need to backfill and compact or grout burrows.					
Inspector Comment					
One of several rodent holes on landside slope.

Looking east at one of several rodent holes on landward slope.

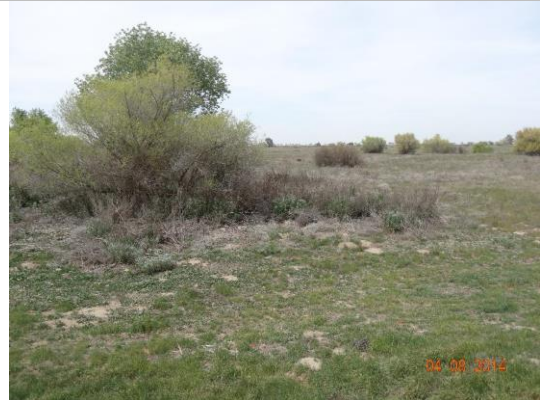
Photo 1 of 3 : UCIP\_SP\_2018\_36849\_67237.jpg

Comment Code					
Inspector Comment					
FS_ID:36849					
DS_ID:19964					
EP_NO: N/A					
Repair Type: Non-Urgent					
Crossing Status: Found					
UCIP Comments: Unable to confirm crossing alignment and appurtenances associated with this crossing. Multiple stand pipes visible on landward side. Need to contact owner to determine status of crossing and alignment.					
FIELD_STRUCT_DESC: 30-inch by 30-inch square reinforced concrete box drainage discharge culvert through the levee, 12.5 feet below the crown. Pump on the landside (LS). Concrete riser with slide gate on the waterside (WS) slope. Screw gate on the LS shoulder. (Plans to construct a new discharge structure and to rehabilitate one existing diversion structure to return intercepted seepage to the San Joaquin River authorized under Permit No. 13085, 1981 - Diener, Dry River Farms). [Additional Reference(s): DWR Levee Log, 2002].					
FS Date: 4/8/2014

View of waterwar side.

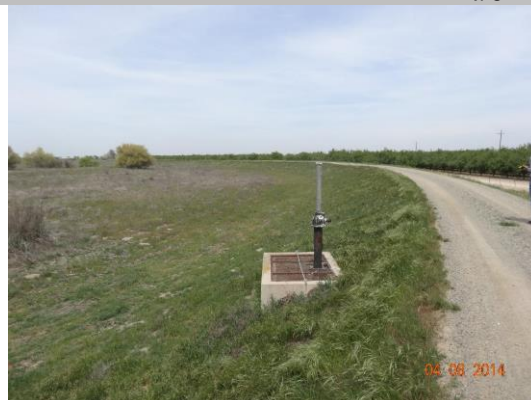
Photo 2 of 3 : UCIP\_SP\_2018\_36849\_67236.jpg

Comment Code						
Inspector Comment						
FS_ID:36849 DS_ID:19964 EP_NO: N/A Repair Type: Non-Urgent Crossing Status: Found UCIP Comments: Unable to confirm crossing alignment and appurtenances associated with this crossing. Multiple stand pipes visible on landward side. Need to contact owner to determine status of crossing and alignment. FIELD_STRUCT_DESC: 30-inch by 30-inch square reinforced concrete box drainage discharge culvert through the levee, 12.5 feet below the crown. Pump on the landside (LS). Concrete riser with slide gate on the waterside (WS) slope. Screw gate on the LS shoulder. (Plans to construct a new discharge structure and to rehabilitate one existing diversion structure to return intercepted seepage to the San Joaquin River authorized under Permit No. 13085, 1981 - Diener, Dry River Farms). [Additional Reference(s): DWR Levee Log, 2002]. FS Date: 4/8/2014

Slide gate inside concrete box located on waterward side.

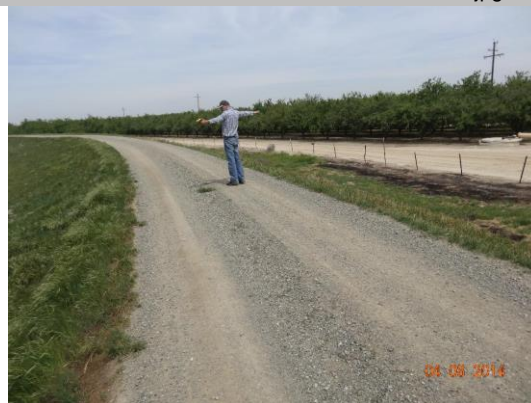
Photo 3 of 3 : UCIP\_SP\_2018\_36849\_67235.jpg

Overview of levee at crossing.

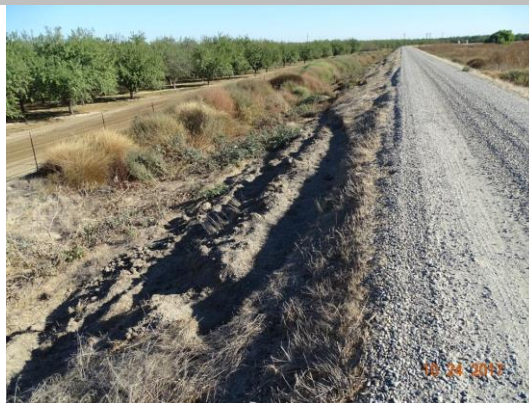
Photo 1 of 1 : SP\_2018\_NA0010\_140\_17\_20180307\_00007.jpg

LM Start	4.27	Rating **	M	Issue No.	17
LM End	4.27	Issue Type +	Ma	Location *	LS
Category	Earthen Levee			GPS Latitude/Longitude	
				Start	End
Item	Slope Stability			36.772003°	36.772003°
				-120.230075°	-120.230075°
DWR ID	DWR_NA0010_24_f_2017_17				
Comment Code					
S3 : Repair the levee slope damaged by vehicle traffic and prevent access where possible.					
Inspector Comment

Looking southeast at the landside slope.

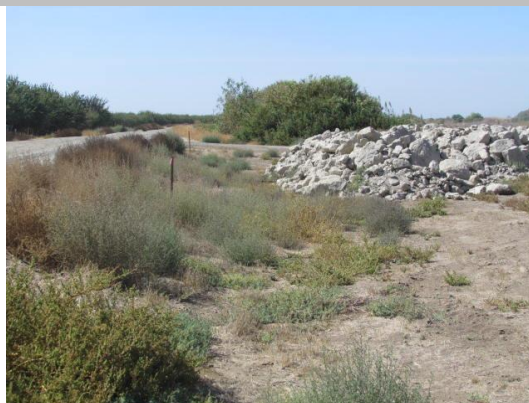
Photo 1 of 2 : SP\_2018\_NA0010\_140\_266\_20180307\_00011.jpg

LM Start	5.29	Rating **	M	Issue No.	266
LM End	5.40	Issue Type +	En	Location *	WS
Category	Earthen Levee			GPS Latitude/Longitude	
				Start	End
Item	Encroachments			36.781926 °	36.782405 °
				-120.224625 °	-120.222763 °
DWR ID	DWR_NA0010_24_s_2015_266				
Comment Code					
MA : Material					
Inspector Comment					
Rocks stockpile near waterside toe.

Looking at rock stockpile on waterward berm. Fall 2015

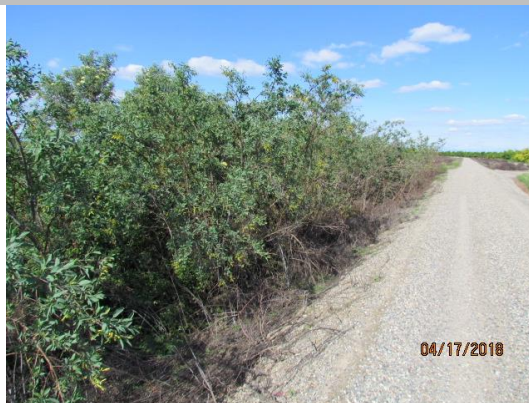
Photo 1 of 1 : SP\_2018\_NA0010\_140\_24\_20180420\_00033.jpg

LM Start	5.35	Rating **	U	Issue No.	24
LM End	5.38	Issue Type +	Ma	Location *	WS
Category	Earthen Levee			GPS Latitude/Longitude	
				Start	End
Item	Vegetation			36.782190 °	36.782314 °
				-120.223599 °	-120.223106 °
DWR ID	DWR_NA0010_24_s_2018_24				
Comment Code					
V7 : Trees / Woody Vegetation					
Inspector Comment					
Possible tobacco plant on waterward slope.

Looking south at dense planting (tobacco plant) on waterward shoulder and slope. (Spring 2018)

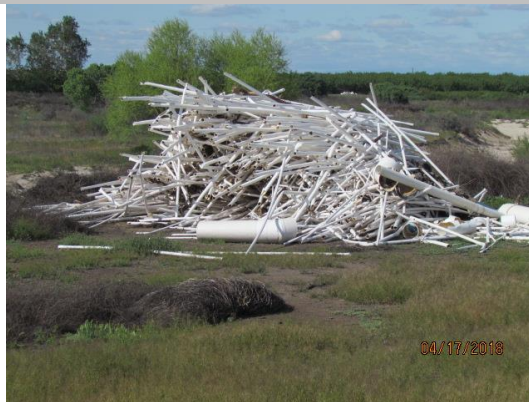
Photo 1 of 1 : SP\_2018\_NA0010\_140\_25\_20180419\_00032.jpg

LM Start	6.30	Rating **	U	Issue No.	25
LM End	6.30	Issue Type +	En	Location *	WS
Category	Earthen Levee			GPS Latitude/Longitude	
				Start	End
Item	Encroachments			36.788095 °	36.788095 °
				-120.210264 °	-120.210264 °
DWR ID	DWR_NA0010_24_s_2018_25				
Comment Code					
MA : Material					
Inspector Comment					
PVC pipe stockpile on waterward berm.

Looking east at pvc pipes on waterward berm. (Spring 2018)

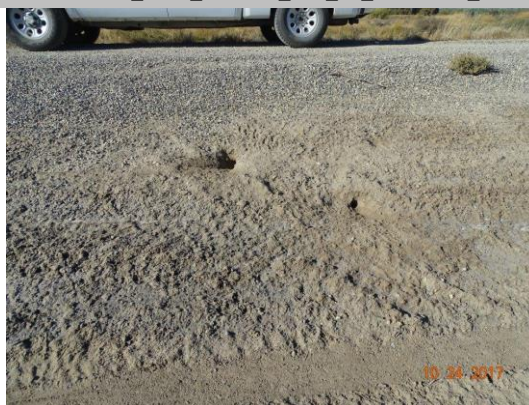
Photo 1 of 2 : SP\_2018\_NA0010\_140\_14\_20180307\_00005.jpg

LM Start	6.35	Rating **	M	Issue No.	14
LM End	6.35	Issue Type +	Ma	Location *	LS
Category	Earthen Levee			GPS Latitude/Longitude	
				Start	End
Item	Animal Control			36.788225 °	36.788225 °
				-120.209357 °	-120.209357 °
DWR ID	DWR_NA0010_24_s_2017_14				
Comment Code					
A3 : No rodents visible, but rodent burrows visible; need to backfill and compact or grout burrows.					
Inspector Comment					
Several rodent holes on levee landside shoulder and slope.

Looking north at the landside slope.

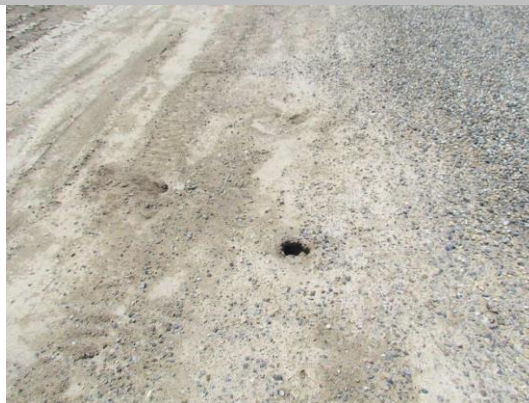
Photo 2 of 2 : SP\_2018\_NA0010\_140\_14\_20180307\_00006.jpg

LM Start	<b>6.35</b>	Rating **	M	Issue No.	<b>14 (cont)</b>
LM End	<b>6.35</b>	Issue Type +	Ma	Location *	LS

Looking at typical view of rodent holes within this section on landward shoulder and slope.

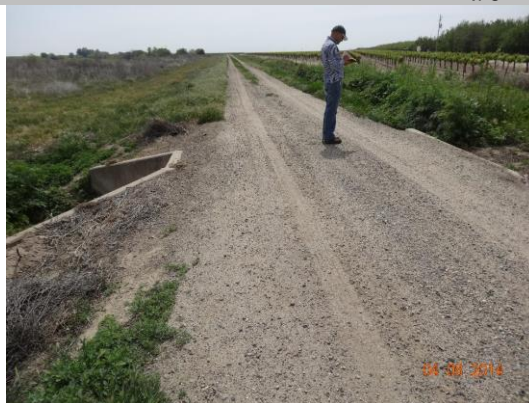
Photo 1 of 3 : UCIP\_SP\_2018\_50056\_60105.jpg

Comment Code					
Inspector Comment					
FS_ID:50056 DS_ID:19957 EP_NO: N/A Repair Type: Non-Urgent Crossing Status: Found UCIP Comments: 7/20/2016 same as previous inspection. Crossing has been downgraded from Urgent to Non-Urgent PVC does not prevent WS flap gate from closing. (DWR UCIP - omagana)4/08/2014 Unauthorized PVC pipe through existng crossing. PVC distorted inside--Need to contact owner to correct issue. If crossing was allowed need to contact owner for permit number issue for crossing variance. (DWR UCIP - omagana) FIELD_STRUCT_DESC: 24-inch corrugated metal gravity drainage pipe through the levee, 3.6 feet below the crown. Flap gate on the waterside (WS) end. Concrete headwall on the landside (LS) end. Concrete U-shaped headwall on the WS end. [Additional Reference(s): DWR Levee Log, 2002]. FS Date: 7/20/2016

Overview of levee crown at crossing.

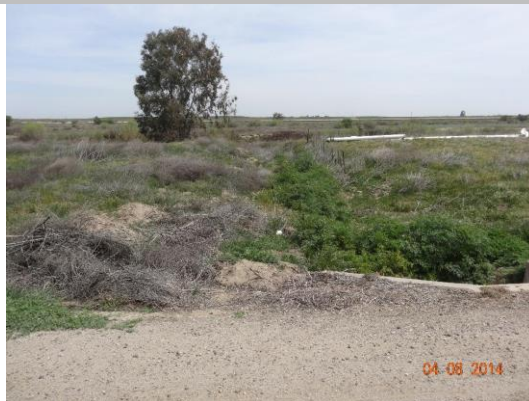
Photo 2 of 3 : UCIP\_SP\_2018\_50056\_60107.jpg

View of WS--debris (pipe sections) located on waterward side.

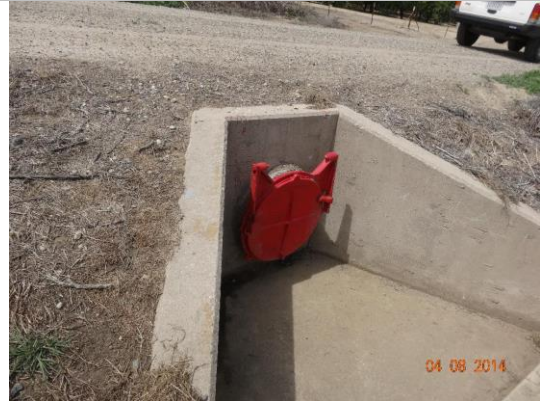
Photo 3 of 3 : UCIP\_SP\_2018\_50056\_60106.jpg

Comment Code						
Inspector Comment						
FS_ID:50056 DS_ID:19957 EP_NO: N/A Repair Type: Non-Urgent Crossing Status: Found UCIP Comments: 7/20/2016 same as previous inspection. Crossing has been downgraded from Urgent to Non-Urgent PVC does not prevent WS flap gate from closing. (DWR UCIP - omagana)4/08/2014 Unauthorized PVC pipe through existng crossing. PVC distorted inside--Need to contact owner to correct issue. If crossing was allowed need to contact owner for permit number issue for crossing variance. (DWR UCIP - omagana) FIELD_STRUCT_DESC: 24-inch corrugated metal gravity drainage pipe through the levee, 3.6 feet below the crown. Flap gate on the waterside (WS) end. Concrete headwall on the landside (LS) end. Concrete U-shaped headwall on the WS end. [Additional Reference(s): DWR Levee Log, 2002]. FS Date: 7/20/2016

Flap gate visible on WS.

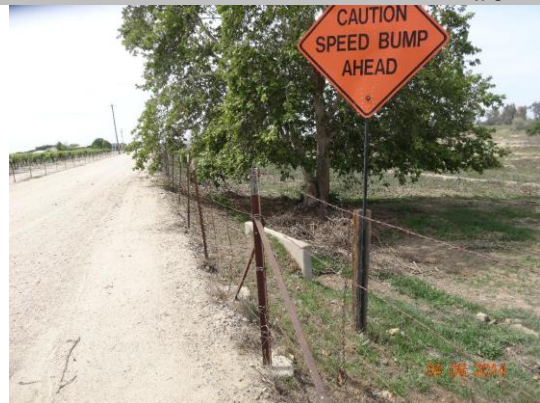
Photo 1 of 2 : UCIP\_SP\_2018\_33272\_60121.jpg

LM Start	8.33	Rating **	M	Issue No.	273
LM End	8.33	Issue Type +	Ma	Location *	
Category	Supplemental			GPS Latitude/Longitude	
				Start	End
Item	DWR UCIP LMA Responsibility			36.778084 °	36.778084 °
				-120.184454 °	-120.184454 °
DWR ID					
Comment Code					
Inspector Comment					
FS_ID:33272 DS_ID:19960 EP_NO: N/A Repair Type: Non-Urgent Crossing Status: Found UCIP Comments: Barbed wire along levee shoulder--no access. Need to confirm crossing size and condition of crossing. FIELD_STRUCT_DESC: 12-inch reinforced concrete gravity drainage pipe through the levee, 3 feet below the crown. Flap gate on the waterside (WS) end. Concrete headwall on the WS end. [Additional Reference(s): DWR Levee Log, 2002. USACE San Joaquin O&M Manual 601.1, 1967, (HLM 8.32)]. FS Date: 4/8/2014

View of waterward side.

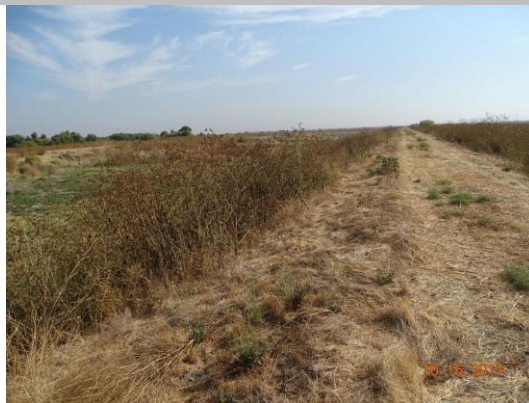
Photo 1 of 2 : SP\_2018\_NA0010\_141\_7\_20180307\_00001.jpg

LM Start	0.00	Rating **	U	Issue No.	7
LM End	1.00	Issue Type +	Ma	Location *	LS
Category	Earthen Levee			GPS Latitude/Longitude	
				Start	End
Item	Vegetation			37.296261 °	37.281769 °
				-120.880678 °	-120.880745 °
DWR ID	DWR_NA0010_25_f_2015_7				
Comment Code					
V2 : Remove the wild growth other than native grasses from the levee slopes.					
Inspector Comment

Looking south at the landside slope.

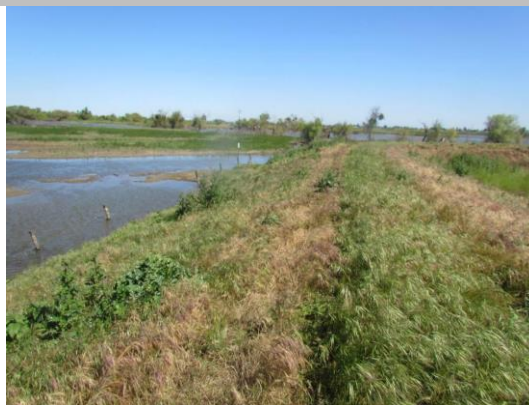
Photo 2 of 2 : SP\_2018\_NA0010\_141\_7\_20180307\_00002.jpg

LM Start	<b>0.00</b>	Rating **	U	Issue No.	<b>7 (cont)</b>
LM End	<b>1.00</b>	Issue Type +	Ma	Location *	LS

Looking at typical view of landward slope.

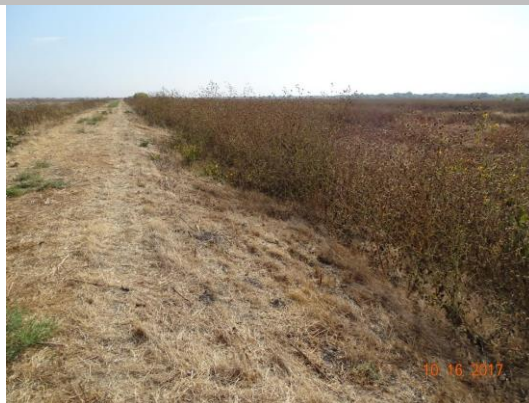
Photo 1 of 2 : SP\_2018\_NA0010\_141\_9\_20180307\_00005.jpg

LM Start	0.00	Rating **	M	Issue No.	9
LM End	1.00	Issue Type +	Ma	Location *	WS
Category	Earthen Levee			GPS Latitude/Longitude	
				Start	End
Item	Vegetation			37.296261 °	37.281768 °
				-120.880678 °	-120.880745 °
DWR ID	DWR_NA0010_25_f_2015_9				
Comment Code					
V2 : Remove the wild growth other than native grasses from the levee slopes.					
Inspector Comment

Looking south at the waterside slope.

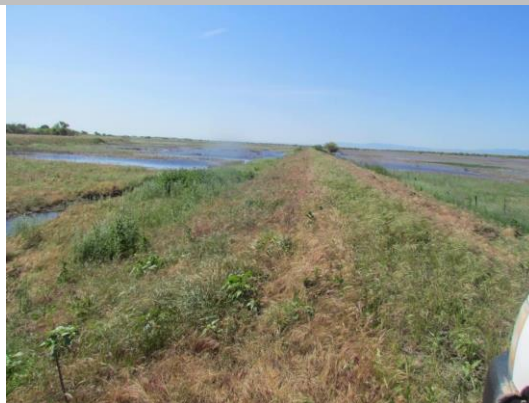
Photo 2 of 2 : SP\_2018\_NA0010\_141\_9\_20180307\_00006.jpg

LM Start	0.00	Rating **	M	Issue No.	9 (cont)	
LM End	1.00	Issue Type +	Ma	Location *	WS	
Category	Earthen Levee			GPS Latitude/Longitude		
				Start		End
Item	Vegetation			37.296261 °		37.281768 °
				-120.880678 °		-120.880745 °
DWR ID	DWR_NA0010_25_f_2015_9					
Comment Code						
V2 : Remove the wild growth other than native grasses from the levee slopes.						
Inspector Comment

Looking typical view of waterward slope.

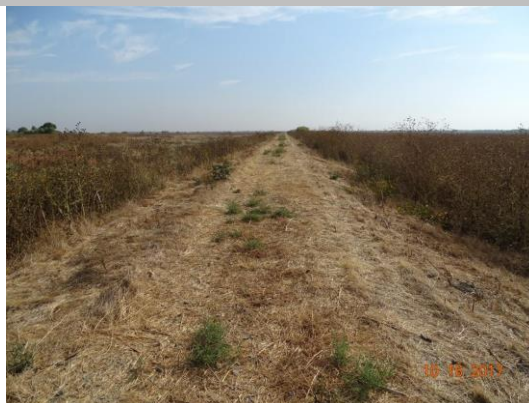
Photo 1 of 2 : SP\_2018\_NA0010\_141\_8\_20180307\_00003.jpg

LM Start	0.00	Rating **	M	Issue No.	8
LM End	1.76	Issue Type +	Ma	Location *	CR
Category	Earthen Levee			GPS Latitude/Longitude	
				Start	End
Item	Vegetation			37.296259 °	37.281615 °
				-120.880677 °	-120.867133 °
DWR ID	DWR_NA0010_25_s_2012_8				
Comment Code					
V2 : Remove the wild growth other than native grasses from the levee slopes.					
Inspector Comment					
Control weeds on levee crown.

Looking south at the levee crown.

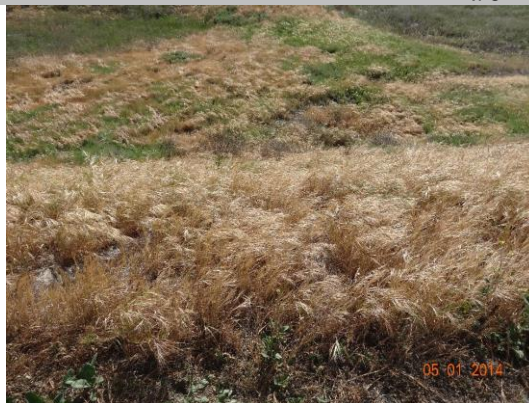
Photo 3 of 3 : UCIP\_SP\_2018\_39501\_67241.jpg

Comment Code						
Inspector Comment						
FS_ID:39501 DS_ID:19965 EP_NO: N/A Repair Type: Non-Urgent Crossing Status: Found UCIP Comments: Dense vegetation limits the inspectors visibility to identify signs of pipe failure (leaks) along the slope. Recommend removing vegetation along pipe alignment to conduct proper inspection of structure. Sediment buildup in pipe visible from landward side--recommend clearing. FIELD_STRUCT_DESC: 24-inch corrugated metal gravity drainage pipe through the levee, 10 feet below the crown. Flap gate on the waterside (WS) end. [Additional Reference(s): DWR Levee Log, 2002. USACE San Joaquin O&M Manual 601.1, 1967, (HLM 0.02)]. FS Date: 5/1/2014

View of landward side--dense vegetation on landward side.

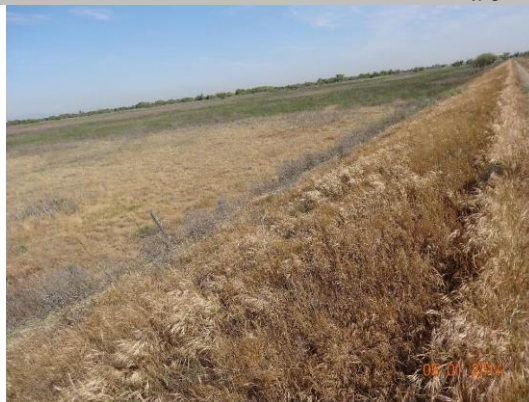
Photo 1 of 3 : UCIP\_SP\_2018\_36851\_67249.jpg

LM Start	0.36	Rating **	M	Issue No.	15
LM End	0.36	Issue Type +	Ma	Location *	
Category	Supplemental			GPS Latitude/Longitude	
				Start	End
Item	DWR UCIP LMA Responsibility			37.291173 °	37.291173 °
				-120.880731 °	-120.880731 °
DWR ID					
Comment Code					
Inspector Comment					
FS_ID:36851 DS_ID:19966 EP_NO: N/A Repair Type: Non-Urgent Crossing Status: Found UCIP Comments: Dense vegetation limits the inspectors visibility to identify signs of pipe failure (leaks) along the slope. Recommend removing vegetation along pipe alignment to conduct proper inspection of structure. FIELD_STRUCT_DESC: 24-inch corrugated metal gravity drainage pipe through the levee, 11.6 feet below the crown. Flap gate on the waterside (WS) end. [Additional Reference(s): DWR Levee Log, 2002. USACE San Joaquin O&M Manual 601.1, 1967, (HLM 0.35)]. FS Date: 5/1/2014

View of waterward side.

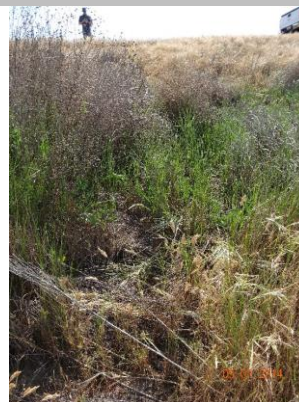
Photo 2 of 3 : UCIP\_SP\_2018\_36852\_67251.jpg

Comment Code						
Inspector Comment						
FS_ID:36852						
DS_ID:19967						
EP_NO: N/A						
Repair Type: Non-Urgent						
Crossing Status: Found						
UCIP Comments: Dense vegetation limits the inspectors visibility to identify signs of pipe failure (leaks) along the slope. Recommend removing vegetation along pipe alignment to conduct proper inspection of structure.						
FIELD_STRUCT_DESC: 24-inch corrugated metal gravity drainage pipe through the levee, 14.7 feet below the crown. Flap gate on the waterside (WS) end. [Additional Reference(s): DWR Levee Log, 2002. USACE San Joaquin O&M Manual 601.1, 1967, (HLM 0.59)].						
FS Date: 5/1/2014

View of waterward slope covered by dense vegetation.

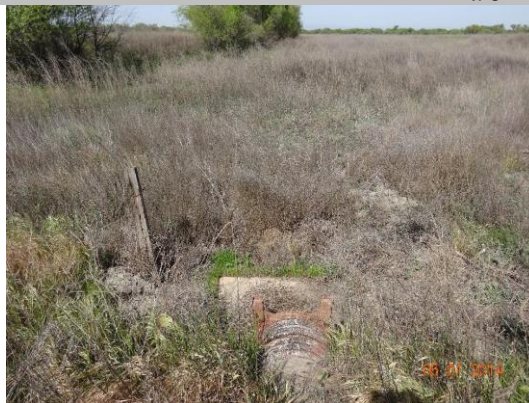
Photo 3 of 3 : UCIP\_SP\_2018\_36852\_67252.jpg

LM Start	0.59	Rating **	M	Issue No.	16 (cont)	
LM End	0.59	Issue Type +	Ma	Location *		
Category	Supplemental			GPS Latitude/Longitude		
				Start		End
Item	DWR UCIP LMA Responsibility			37.287744 °	37.287744 °	
				-120.880645 °	-120.880645 °	
DWR ID						
Comment Code						
Inspector Comment						
FS_ID:36852 DS_ID:19967 EP_NO: N/A Repair Type: Non-Urgent Crossing Status: Found UCIP Comments: Dense vegetation limits the inspectors visibility to identify signs of pipe failure (leaks) along the slope. Recommend removing vegetation along pipe alignment to conduct proper inspection of structure. FIELD_STRUCT_DESC: 24-inch corrugated metal gravity drainage pipe through the levee, 14.7 feet below the crown. Flap gate on the waterside (WS) end. [Additional Reference(s): DWR Levee Log, 2002. USACE San Joaquin O&M Manual 601.1, 1967, (HLM 0.59)]. FS Date: 5/1/2014

Pipe and flap gate visible on waterward side.

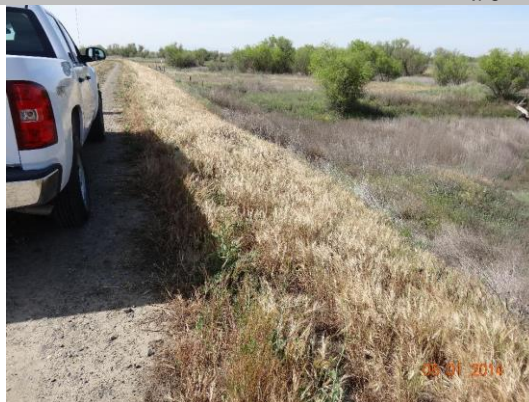
Photo 1 of 3 : UCIP\_SP\_2018\_36853\_67256.jpg

LM Start	0.97	Rating **	M	Issue No.	17
LM End	0.97	Issue Type +	Ma	Location *	
Category	Supplemental			GPS Latitude/Longitude	
				Start	End
Item	DWR UCIP LMA Responsibility			37.282252 °	37.282252 °
				-120.880738 °	-120.880738 °
DWR ID					
Comment Code					
Inspector Comment					
FS_ID:36853 DS_ID:19968 EP_NO: N/A Repair Type: Non-Urgent Crossing Status: Found UCIP Comments: Dense vegetation limits the inspectors visibility to identify signs of pipe failure (leaks) along the slope. Recommend removing vegetation along pipe alignment to conduct proper inspection of structure. FIELD_STRUCT_DESC: 24-inch corrugated metal gravity drainage pipe through the levee, 11.4 feet below the crown. Flap gate on the waterside (WS) end. [Additional Reference(s): DWR Levee Log, 2002. USACE San Joaquin O&M Manual 601.1, 1967, (HLM 0.97)]. FS Date: 5/1/2014

View of waterward side.

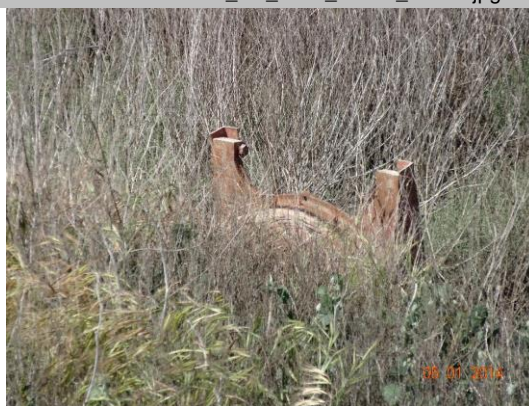
Photo 2 of 3 : UCIP\_SP\_2018\_36853\_67255.jpg

LM Start	0.97	Rating **	M	Issue No.	17 (cont)	
LM End	0.97	Issue Type +	Ma	Location *		
Category	Supplemental			GPS Latitude/Longitude		
				Start		End
Item	DWR UCIP LMA Responsibility			37.282252 °		37.282252 °
				-120.880738 °		-120.880738 °
DWR ID						
Comment Code						
Inspector Comment						
FS_ID:36853 DS_ID:19968 EP_NO: N/A Repair Type: Non-Urgent Crossing Status: Found UCIP Comments: Dense vegetation limits the inspectors visibility to identify signs of pipe failure (leaks) along the slope. Recommend removing vegetation along pipe alignment to conduct proper inspection of structure. FIELD_STRUCT_DESC: 24-inch corrugated metal gravity drainage pipe through the levee, 11.4 feet below the crown. Flap gate on the waterside (WS) end. [Additional Reference(s): DWR Levee Log, 2002. USACE San Joaquin O&M Manual 601.1, 1967, (HLM 0.97)]. FS Date: 5/1/2014

Pipe and evidence of flap gate visible on waterward side.

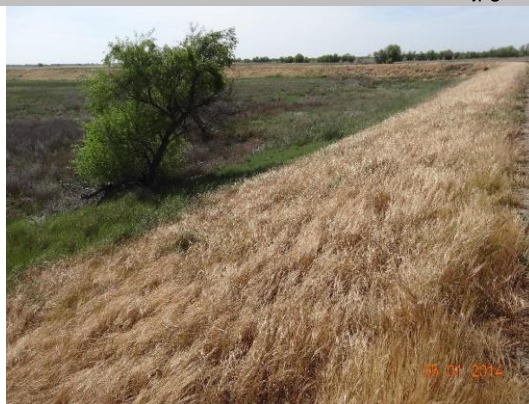
Photo 3 of 3 : UCIP\_SP\_2018\_36853\_67254.jpg

View of landward side.

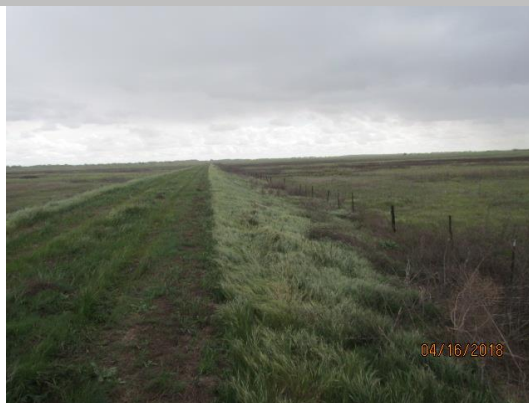
Photo 1 of 1 : SP\_2018\_NA0010\_141\_11\_20180419\_00025.jpg

LM Start	1.00	Rating **	M	Issue No.	11
LM End	2.49	Issue Type +	Ma	Location *	WS
Category	Earthen Levee			GPS Latitude/Longitude	
				Start	End
Item	Vegetation			37.281791 °	37.271073 °
				-120.880747 °	-120.866562 °
DWR ID	DWR_NA0010_25_s_2018_11				
Comment Code					
V1 : Control annual grass and weeds on the levee slopes and easements.					
Inspector Comment

Looking northeast at typical view of waterward slope. (Spring 2018)

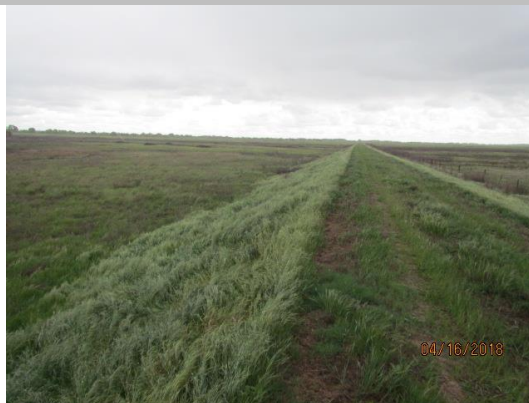
Photo 1 of 1 : SP\_2018\_NA0010\_141\_10\_20180419\_00026.jpg

LM Start	1.00	Rating **	M	Issue No.	10
LM End	2.49	Issue Type +	Ma	Location *	LS
Category	Earthen Levee			GPS Latitude/Longitude	
				Start	End
Item	Vegetation			37.281791 °	37.271073 °
				-120.880746 °	-120.866562 °
DWR ID	DWR_NA0010_25_s_2018_10				
Comment Code					
V1 : Control annual grass and weeds on the levee slopes and easements.					
Inspector Comment

Looking north at typical view of landward slope. (Spring 2018)

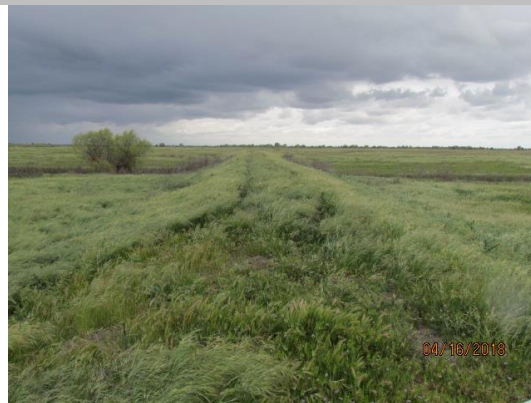
Photo 1 of 1 : SP\_2018\_NA0010\_141\_12\_20180419\_00027.jpg

LM Start	1.75	Rating **	U	Issue No.	12
LM End	2.49	Issue Type +	Ma	Location *	CR
Category	Earthen Levee			GPS Latitude/Longitude	
				Start	End
Item	Vegetation			37.281677 °	37.271073 °
				-120.867254 °	-120.866562 °
DWR ID	DWR_NA0010_25_s_2018_12				
Comment Code					
V2 : Remove the wild growth other than native grasses from the levee slopes.					
Inspector Comment

Looking east at typical view of levee crown. (Spring 2018)

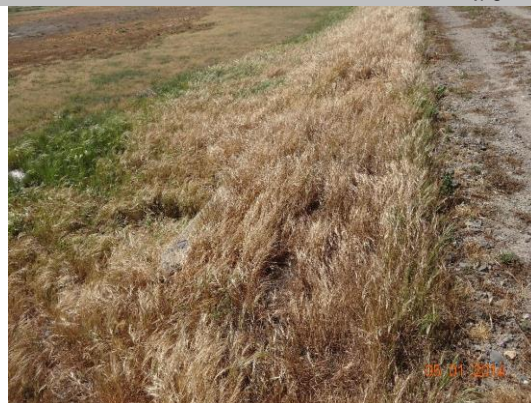
Photo 1 of 3 : UCIP\_SP\_2018\_36854\_67259.jpg

LM Start	2.05	Rating **	M	Issue No.	18
LM End	2.05	Issue Type +	Ma	Location *	
Category	Supplemental			GPS Latitude/Longitude	
				Start	End
Item	DWR UCIP LMA Responsibility			37.277390 °	37.277390 °
				-120.867184 °	-120.867184 °
DWR ID					
Comment Code					
Inspector Comment					
FS_ID:36854 DS_ID:19969 EP_NO: N/A Repair Type: Non-Urgent Crossing Status: Found UCIP Comments: Dense vegetation limits the inspectors visibility to identify signs of pipe failure (leaks) along the slope. Recommend removing vegetation along pipe alignment to conduct proper inspection of structure. FIELD_STRUCT_DESC: 24-inch corrugated metal gravity drainage pipe through the levee, 4 feet below the crown. Flap gate on the waterside (WS) end. [Additional Reference(s): DWR Levee Log, 2002. USACE San Joaquin O&M Manual 601.1, 1967, (HLM 2.05)]. FS Date: 5/1/2014

View of landward side.

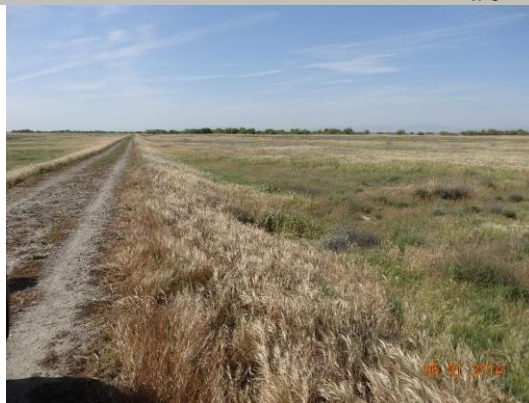
Photo 2 of 3 : UCIP\_SP\_2018\_36854\_67260.jpg

LM Start	2.05	Rating **	M	Issue No.	18 (cont)	
LM End	2.05	Issue Type +	Ma	Location *		
Category	Supplemental			GPS Latitude/Longitude		
				Start		End
Item	DWR UCIP LMA Responsibility			37.277390 °		37.277390 °
				-120.867184 °		-120.867184 °
DWR ID						
Comment Code						
Inspector Comment						
FS_ID:36854 DS_ID:19969 EP_NO: N/A Repair Type: Non-Urgent Crossing Status: Found UCIP Comments: Dense vegetation limits the inspectors visibility to identify signs of pipe failure (leaks) along the slope. Recommend removing vegetation along pipe alignment to conduct proper inspection of structure. FIELD_STRUCT_DESC: 24-inch corrugated metal gravity drainage pipe through the levee, 4 feet below the crown. Flap gate on the waterside (WS) end. [Additional Reference(s): DWR Levee Log, 2002. USACE San Joaquin O&M Manual 601.1, 1967, (HLM 2.05)]. FS Date: 5/1/2014

View of waterward side.

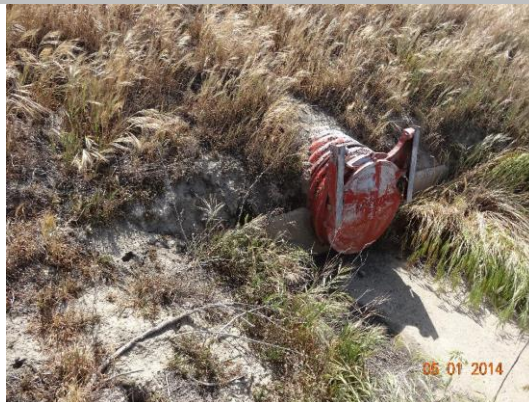
Photo 3 of 3 : UCIP\_SP\_2018\_36854\_67261.jpg

Flap gate and concrete headwall located on waterward toe.

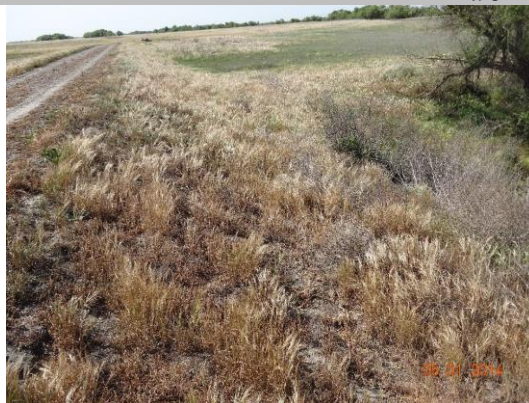
Photo 1 of 3 : UCIP\_SP\_2018\_39502\_67270.jpg

Comment Code					
Inspector Comment					
FS_ID:39502 DS_ID:19970 EP_NO: N/A Repair Type: Non-Urgent Crossing Status: Found UCIP Comments: Dense vegetation limits the inspectors visibility to identify signs of pipe failure (leaks) along the slope. Recommend removing vegetation along pipe alignment to conduct proper inspection of structure. Sediment buildup in pipe visible on landward side--recommend clearing. FIELD_STRUCT_DESC: 24-inch corrugated metal gravity drainage pipe through the levee, 11.2 feet below the crown. Flap gate on the waterside (WS) end. [Additional Reference(s): DWR Levee Log, 2002. USACE San Joaquin O&M Manual 601.1, 1967, (HLM 2.45)]. FS Date: 5/1/2014 4:04:00 PM

View of waterward side.

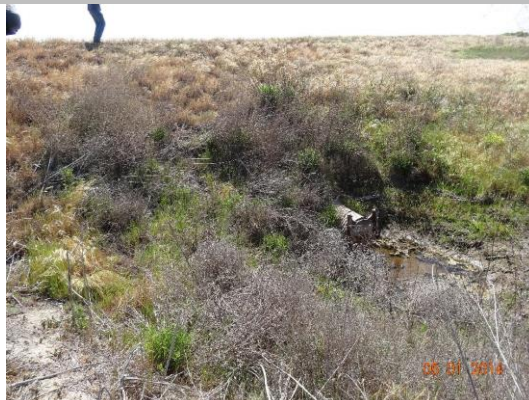
Photo 2 of 3 : UCIP\_SP\_2018\_39502\_67269.jpg

Pipe daylights at waterward toe.

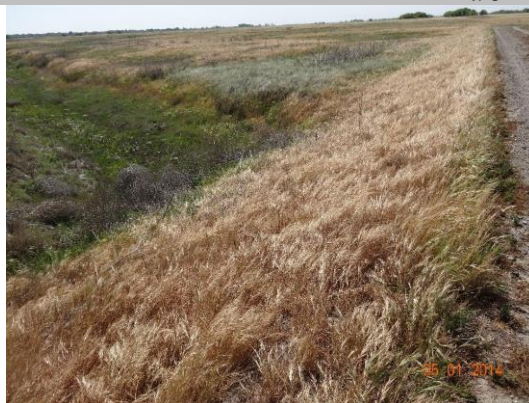
Photo 3 of 3 : UCIP\_SP\_2018\_39502\_67268.jpg

Comment Code						
Inspector Comment						
FS_ID:39502 DS_ID:19970 EP_NO: N/A Repair Type: Non-Urgent Crossing Status: Found UCIP Comments: Dense vegetation limits the inspectors visibility to identify signs of pipe failure (leaks) along the slope. Recommend removing vegetation along pipe alignment to conduct proper inspection of structure. Sediment buildup in pipe visible on landward side--recommend clearing. FIELD_STRUCT_DESC: 24-inch corrugated metal gravity drainage pipe through the levee, 11.2 feet below the crown. Flap gate on the waterside (WS) end. [Additional Reference(s): DWR Levee Log, 2002. USACE San Joaquin O&M Manual 601.1, 1967, (HLM 2.45)]. FS Date: 5/1/2014 4:04:00 PM

View of landward side.
