**Flood Control Project Maintenance
Levee Inspections**
LMA District Cover Sheet
Spring 2019 Levee Inspection Results

Lower San Joaquin Levee District

Spring 2019 Levee Inspection Results

Waterway			Bank	Unit Miles
Unit No. 01 San Joaquin River			Right	22.52
	Spring (March - May)	Summer (June - August)	(September - November) Fall	Winter (December - February)
Unit Maintenance Rating (Fall Only)				
Date of Inspection	3/26/2019 - 3/26/2019			
DWR Inspector	Corey Fujitani			
Accompanied By

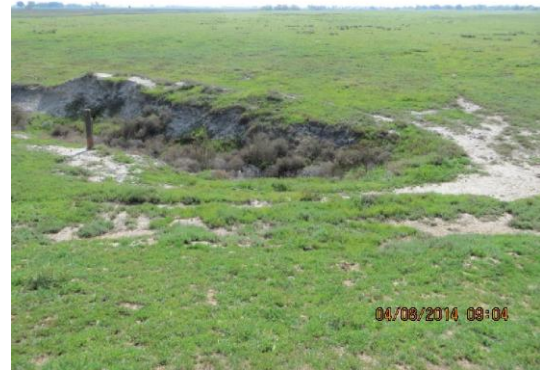
Photo 3 of 3 : UCIP_SP_2019_39092_60612.jpg

Comment Code						
Inspector Comment						
FS_ID:39092 DS_ID:19651 EP_NO: N/A Repair Type: Non-Urgent Crossing Status: Found UCIP Comments: 04/08/2014 Pipe has significant sediment buildup and shows some signs of corrosion at landward toe. Recommend cleaning sediment from inside pipe and check wall integrity. (DWR UCIP - W. Wylie) FIELD_STRUCT_DESC: 36-inch corrugated metal gravity drainage pipe through the levee, 18.5 feet below the crown. Flap gate on the waterside (WS) end. Brass cap No. 108 bench mark (BM) on the headwall on the landside (LS). [Additional Reference(s): DWR Levee Log, 2002. USACE San Joaquin O&M Manual 601.1, 1967, (HLM 0.35)]. FS Date: 4/8/2014

Pipe and headwall visible off LS toe.

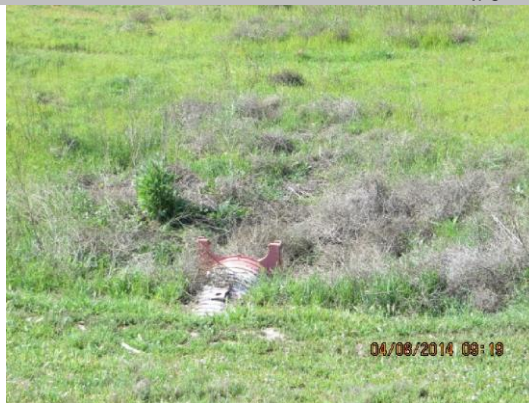
Photo 1 of 3 : UCIP_SP_2019_33524_60627.jpg

LM Start	0.85	Rating **	A/W	Issue No.	1188
LM End	0.85	Issue Type +	Ma	Location *	
Category	Supplemental			GPS Latitude/Longitude	
				Start	End
Item	DWR UCIP LMA Responsibility			37.339829 °	37.339829 °
				-120.958621 °	-120.958621 °
DWR ID	19584				
Comment Code					
Inspector Comment					
FS_ID:33524					
DS_ID:19584					
EP_NO: N/A					
Repair Type: No Action Needed					
Crossing Status: Found					
UCIP Comments:					
FIELD_STRUCT_DESC: 24-inch corrugated metal gravity drainage pipe through the levee, 7 feet below the crown. Flap gate on the waterside (WS) end. Brass cap No. 108 bench mark (BM) on the headwall on the landside (LS). [Additional Reference(s): DWR Levee Log, 2002. USACE San Joaquin O&M Manual 601.1, 1967, (HLM 0.87)].					
FS Date: 4/8/2014

Pipe, flapgate, and headwall visible on WS toe.

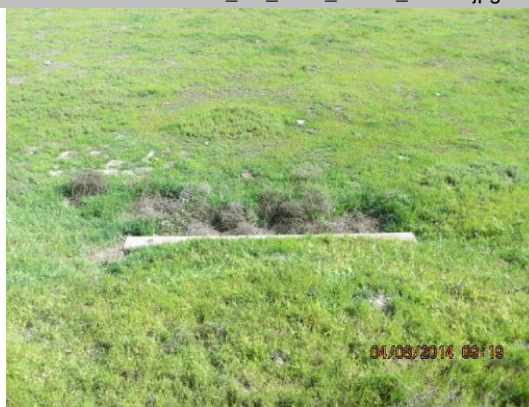
Photo 2 of 3 : UCIP_SP_2019_33524_60626.jpg

Pipe and headwall visible on LS toe.

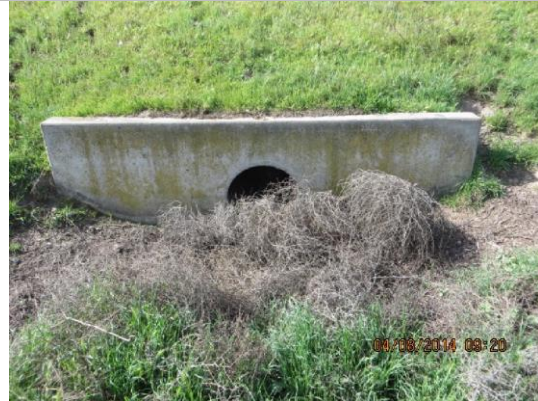
Photo 3 of 3 : UCIP_SP_2019_33524_60625.jpg

LM Start	0.85	Rating **	A/W	Issue No.	1188 (cont)	
LM End	0.85	Issue Type +	Ma	Location *		
Category	Supplemental			GPS Latitude/Longitude		
				Start	End	
Item	DWR UCIP LMA Responsibility			37.339829 °	37.339829 °	
				-120.958621 °	-120.958621 °	
DWR ID	19584					
Comment Code						
Inspector Comment						
FS_ID:33524						
DS_ID:19584						
EP_NO: N/A						
Repair Type: No Action Needed						
Crossing Status: Found						
UCIP Comments:						
FIELD_STRUCT_DESC: 24-inch corrugated metal gravity drainage pipe						
through the levee, 7 feet below the crown. Flap gate on the waterside						
(WS) end. Brass cap No. 108 bench mark (BM) on the headwall on the						
landside (LS). [Additional Reference(s): DWR Levee Log, 2002. USACE						
San Joaquin O&M Manual 601.1, 1967, (HLM 0.87)].						
FS Date: 4/8/2014

Pipe and headwall visible on LS toe.

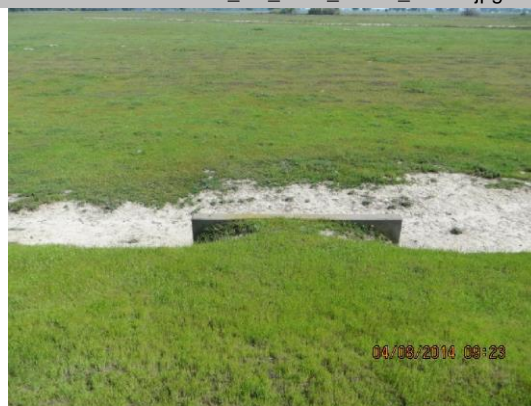
Photo 2 of 3 : UCIP_SP_2019_39096_60631.jpg

Comment Code						
Inspector Comment						
FS_ID:39096 DS_ID:19585 EP_NO: N/A Repair Type: Non-Urgent Crossing Status: Found UCIP Comments: 04/08/2014 Moderate erosion around headwall on landward toe. May or may not be an issue. Need to contact owner to determine status of crossing and to address erosion issue on landward side. (DWR UCIP - W. Wylie) FIELD_STRUCT_DESC: 24-inch corrugated metal gravity drainage pipe through the levee, 7 feet below the crown. Flap gate on the waterside (WS) end. Brass cap No. 108 bench mark (BM) on the headwall on the landside (LS). [Additional Reference(s): DWR Levee Log, 2002. USACE San Joaquin O&M Manual 601.1, 1967, (HLM 0.95)]. FS Date: 4/8/2014

Concrete headwall and pipe visible at LS toe.

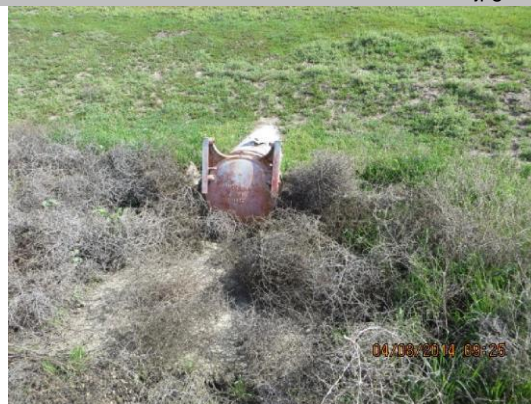
Photo 3 of 3 : UCIP_SP_2019_39096_60633.jpg

Flapgate, pipe, and headwall on WS toe.

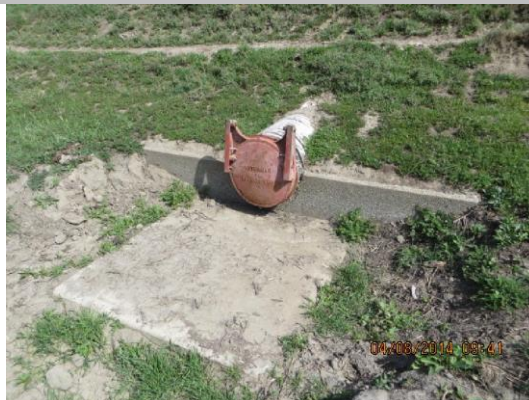
Photo 2 of 3 : UCIP_SP_2019_39099_60653.jpg

Comment Code						
Inspector Comment						
FS_ID:39099						
DS_ID:19588						
EP_NO: N/A						
Repair Type: Non-Urgent						
Crossing Status: Found						
UCIP Comments: 04/08/2014 Some sediment buildup inside pipe at LS toe. Recommend contacting owner to clear sediment buildup and check wall integrity through pipe section. (DWR UCIP - W. Wylie)						
FIELD_STRUCT_DESC: 24-inch corrugated metal gravity drainage pipe through the levee, 11 feet below the crown. Flap gate on the waterside (WS) end. Brass cap No. 108 bench mark (BM) on the headwall on the landside (LS). [Additional Reference(s): DWR Levee Log, 2002. USACE San Joaquin O&M Manual 601.1, 1967, (HLM 1.48)].						
FS Date: 4/8/2014

Pipe, flapgate, and concrete headwall visible on WS toe.

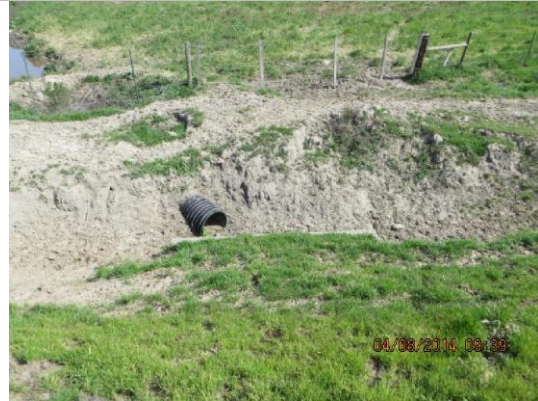
Photo 3 of 3 : UCIP_SP_2019_39099_60651.jpg

Comment Code						
Inspector Comment						
FS_ID:39099 DS_ID:19588 EP_NO: N/A Repair Type: Non-Urgent Crossing Status: Found UCIP Comments: 04/08/2014 Some sediment buildup inside pipe at LS toe. Recommend contacting owner to clear sediment buildup and check wall integrity through pipe section. (DWR UCIP - W. Wylie) FIELD_STRUCT_DESC: 24-inch corrugated metal gravity drainage pipe through the levee, 11 feet below the crown. Flap gate on the waterside (WS) end. Brass cap No. 108 bench mark (BM) on the headwall on the landside (LS). [Additional Reference(s): DWR Levee Log, 2002. USACE San Joaquin O&M Manual 601.1, 1967, (HLM 1.48)]. FS Date: 4/8/2014

Pipe and concrete headwall visible on LS toe.

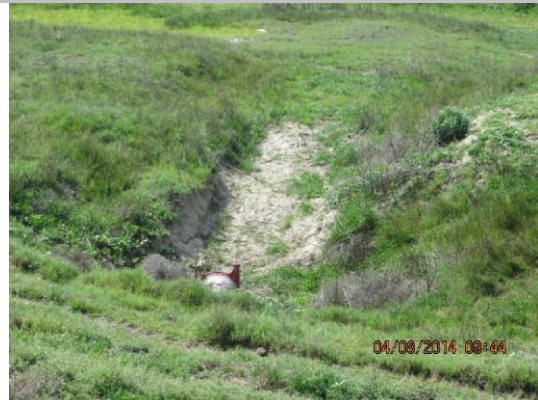
Photo 1 of 3 : UCIP_SP_2019_33563_60661.jpg

LM Start	1.67	Rating **	M	Issue No.	1193
LM End	1.67	Issue Type +	Ma	Location *	
Category	Supplemental			GPS Latitude/Longitude	
				Start	End
Item	DWR UCIP LMA Responsibility			37.336459 °	37.336459 °
				-120.944803 °	-120.944803 °
DWR ID	19589				
Comment Code					
Inspector Comment					
FS_ID:33563 DS_ID:19589 EP_NO: N/A Repair Type: Non-Urgent Crossing Status: Found UCIP Comments: 04/08/2014 Heavy sediment buildup in pipe at LS toe. (DWR UCIP - W. Wylie) FIELD_STRUCT_DESC: 24-inch corrugated metal gravity drainage pipe through the levee, 13.6 feet below the crown. Flap gate on the waterside (WS) end. Brass cap No. 108 bench mark (BM) on the headwall on the landside (LS). [Additional Reference(s): DWR Levee Log, 2002. USACE San Joaquin O&M Manual 601.1, 1967, (HLM 1.69)]. FS Date: 4/8/2014

Pipe, headwall, and flapgate visible on WS toe.

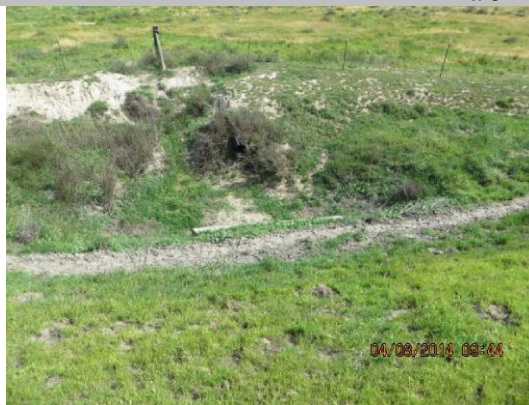
Photo 3 of 3 : UCIP_SP_2019_33563_60662.jpg

LM Start	1.67	Rating **	M	Issue No.	1193 (cont)	
LM End	1.67	Issue Type +	Ma	Location *		
Category	Supplemental			GPS Latitude/Longitude		
				Start		End
Item	DWR UCIP LMA Responsibility			37.336459 °		37.336459 °
				-120.944803 °		-120.944803 °
DWR ID	19589					
Comment Code						
Inspector Comment						
FS_ID:33563						
DS_ID:19589						
EP_NO: N/A						
Repair Type: Non-Urgent						
Crossing Status: Found						
UCIP Comments: 04/08/2014 Heavy sediment buildup in pipe at LS toe. (DWR UCIP - W. Wylie)						
FIELD_STRUCT_DESC: 24-inch corrugated metal gravity drainage pipe through the levee, 13.6 feet below the crown. Flap gate on the waterside (WS) end. Brass cap No. 108 bench mark (BM) on the headwall on the landside (LS). [Additional Reference(s): DWR Levee Log, 2002. USACE San Joaquin O&M Manual 601.1, 1967, (HLM 1.69)].						
FS Date: 4/8/2014

Pipe and headwall visible on LS toe.

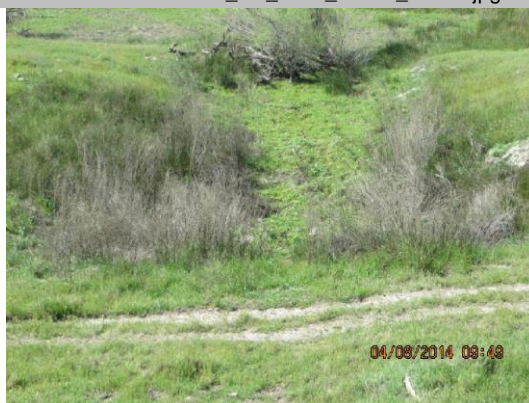
Photo 1 of 3 : UCIP_SP_2019_33564_60666.jpg

LM Start	1.81	Rating **	A/W	Issue No.	1194	
LM End	1.81	Issue Type +	Ma	Location *		
Category	Supplemental			GPS Latitude/Longitude		
				Start	End	
Item	DWR UCIP LMA Responsibility			37.335612 °	37.335612 °	
				-120.942532 °	-120.942532 °	
DWR ID	19590					
Comment Code						
Inspector Comment						
FS_ID:33564						
DS_ID:19590						
EP_NO: N/A						
Repair Type: No Action Needed						
Crossing Status: Found						
UCIP Comments:						
FIELD_STRUCT_DESC: 36-inch corrugated metal gravity drainage pipe						
through the levee, 14.2 feet below the crown. Flap gate on the						
waterside (WS) end. Brass cap No. 100 bench mark (BM) on the						
headwall on the landside (LS). [Additional Reference(s): DWR Levee						
Log, 2002. USACE San Joaquin O&M Manual 601.1, 1967, (HLM 1.83)].						
FS Date: 4/8/2014

Pipe, flapgate, and headwall visible at WS toe.

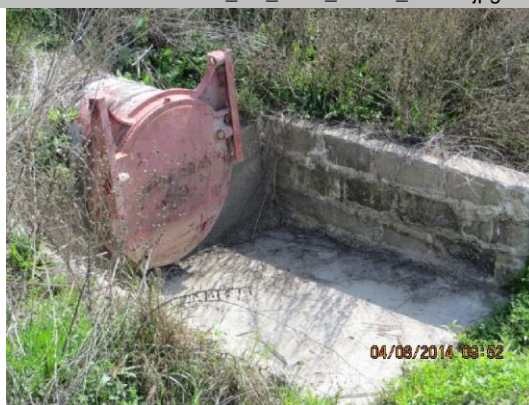
Photo 2 of 3 : UCIP_SP_2019_33564_60667.jpg

Pipe, flapgate, and headwall visible at WS toe.

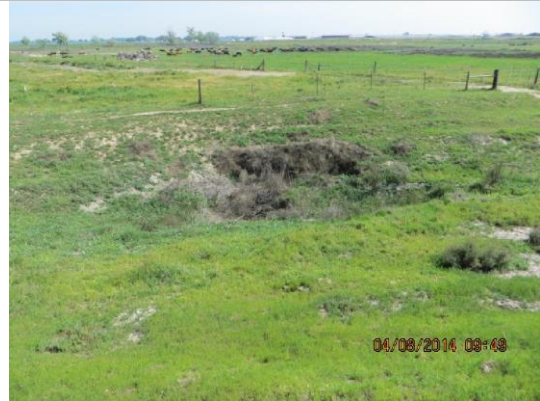
Photo 3 of 3 : UCIP_SP_2019_33564_60665.jpg

LM Start	1.81	Rating **	A/W	Issue No.	1194 (cont)	
LM End	1.81	Issue Type +	Ma	Location *		
Category	Supplemental			GPS Latitude/Longitude		
				Start	End	
Item	DWR UCIP LMA Responsibility			37.335612 °	37.335612 °	
				-120.942532 °	-120.942532 °	
DWR ID	19590					
Comment Code						
Inspector Comment						
FS_ID:33564						
DS_ID:19590						
EP_NO: N/A						
Repair Type: No Action Needed						
Crossing Status: Found						
UCIP Comments:						
FIELD_STRUCT_DESC: 36-inch corrugated metal gravity drainage pipe						
through the levee, 14.2 feet below the crown. Flap gate on the						
waterside (WS) end. Brass cap No. 100 bench mark (BM) on the						
headwall on the landside (LS). [Additional Reference(s): DWR Levee						
Log, 2002. USACE San Joaquin O&M Manual 601.1, 1967, (HLM 1.83)].						
FS Date: 4/8/2014

Pipe and concrete headwall visible at LS toe.

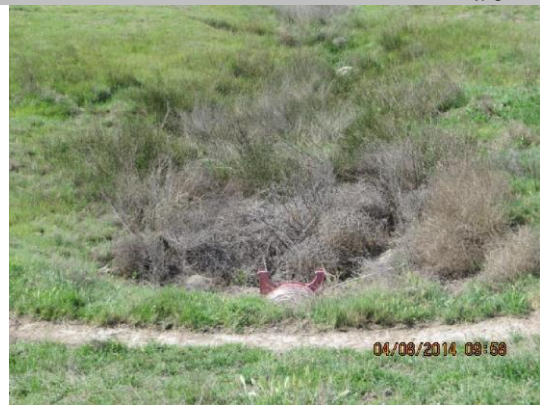
Photo 1 of 3 : UCIP_SP_2019_39100_60670.jpg

Comment Code						
Inspector Comment						
FS_ID:39100 DS_ID:19591 EP_NO: N/A Repair Type: Non-Urgent Crossing Status: Found UCIP Comments: 04/08/2014 Need to contact owner to determine crossing status. Inlet drop box silted in and needs to be cleaned out. (DWR UCIP - W. Wylie) FIELD_STRUCT_DESC: 24-inch corrugated metal gravity drainage pipe through the levee, 9.7 feet below the crown. Flap gate on the waterside (WS) end. Brass cap No. 100 bench mark (BM) on the headwall on the landside (LS). Wooden barrier around drop inlet on the LS toe. [Additional Reference(s): DWR Levee Log, 2002. USACE San Joaquin O&M Manual 601.1, 1967, (HLM 1.98)]. FS Date: 4/8/2014

Concrete headwall and flapgate on WS toe.

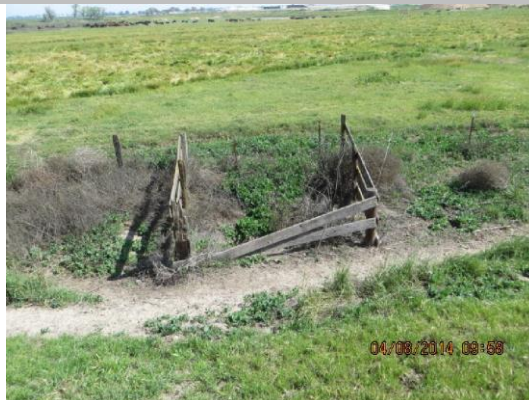
Photo 3 of 3 : UCIP_SP_2019_39100_60671.jpg

Comment Code						
Inspector Comment						
FS_ID:39100						
DS_ID:19591						
EP_NO: N/A						
Repair Type: Non-Urgent						
Crossing Status: Found						
UCIP Comments: 04/08/2014 Need to contact owner to determine crossing status. Inlet drop box silted in and needs to be cleaned out. (DWR UCIP - W. Wylie)						
FIELD_STRUCT_DESC: 24-inch corrugated metal gravity drainage pipe through the levee, 9.7 feet below the crown. Flap gate on the waterside (WS) end. Brass cap No. 100 bench mark (BM) on the headwall on the landside (LS). Wooden barrier around drop inlet on the LS toe. [Additional Reference(s): DWR Levee Log, 2002. USACE San Joaquin O&M Manual 601.1, 1967, (HLM 1.98)].						
FS Date: 4/8/2014

Wooded barrier around drop-inlet on LS toe.

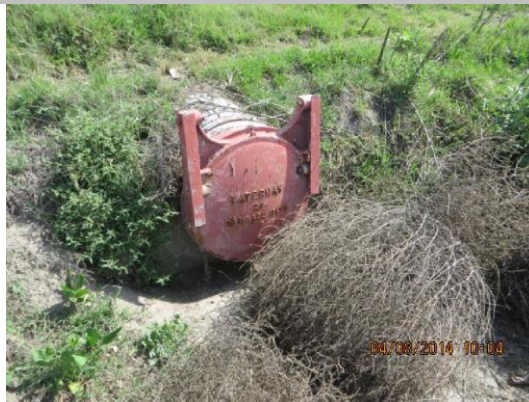
Photo 2 of 3 : UCIP_SP_2019_39123_60676.jpg

LM Start	2.06	Rating **	M	Issue No.	1196 (cont)
LM End	2.06	Issue Type +	Ma	Location *

Pipe and flapgate visible on WS toe.

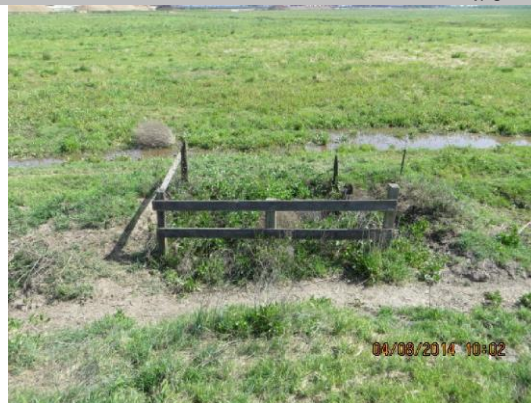
Photo 3 of 3 : UCIP_SP_2019_39123_60674.jpg

LM Start	2.06	Rating **	M	Issue No.	1196 (cont)	
LM End	2.06	Issue Type +	Ma	Location *		
Category	Supplemental			GPS Latitude/Longitude		
				Start		End
Item	DWR UCIP LMA Responsibility			37.333653 °	37.333653 °	
				-120.938770 °	-120.938770 °	
DWR ID	19570					
Comment Code						
Inspector Comment						
FS_ID:39123 DS_ID:19570 EP_NO: N/A Repair Type: Non-Urgent Crossing Status: Found UCIP Comments: 04/08/2014 Unable to find inlet on landward toe. Recommend clearing vegetation on landward side to properly inspect inlet. (DWR UCIP - W. Wylie) FIELD_STRUCT_DESC: 24-inch corrugated metal gravity drainage pipe through the levee, 9.8 feet below the crown. Flap gate on the waterside (WS) end. Brass cap No. 100 bench mark (BM) on the headwall on the landside (LS). [Additional Reference(s): DWR Levee Log, 2002. USACE San Joaquin O&M Manual 601.1, 1967, (HLM 2.08)]. FS Date: 4/8/2014

Wooded barrier around drop-inlet on LS toe.

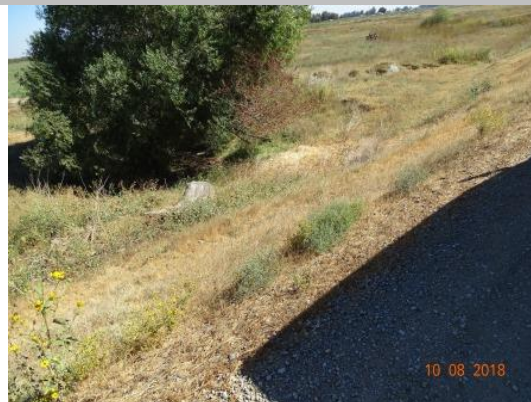
Photo 1 of 2 : SP_2019_NA0010_118_110_20190307_00028.jpg

LM Start	2.20	Rating **	N	Issue No.	110
LM End	2.20	Issue Type +	Ma	Location *	LS
Category	Earthen Levee			GPS Latitude/Longitude	
				Start	End
Item	Trim / Thin Trees			37.331820 °	37.331820 °
				-120.937605 °	-120.937605 °
DWR ID	DWR_NA0010_01_f_2018_110				
Comment Code					
T5 : Tree stumps.					
Inspector Comment					
Tree stump on landside slope should be removed

View of tree stump on landside slope. (Fall 2018)

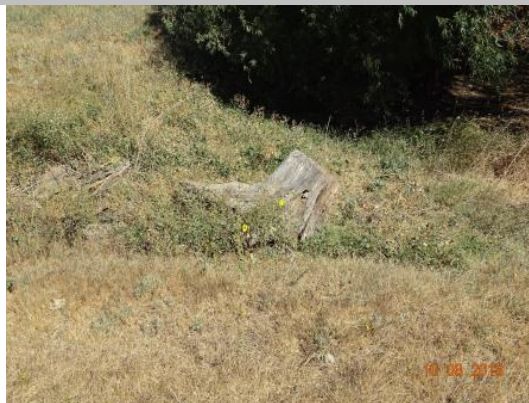
Photo 2 of 2 : SP_2019_NA0010_118_110_20190307_00029.jpg

LM Start	2.20	Rating **	N	Issue No.	110 (cont)	
LM End	2.20	Issue Type +	Ma	Location *	LS	
Category	Earthen Levee			GPS Latitude/Longitude		
				Start		End
Item	Trim / Thin Trees			37.331820 °		37.331820 °
				-120.937605 °		-120.937605 °
DWR ID	DWR_NA0010_01_f_2018_110					
Comment Code						
T5 : Tree stumps.						
Inspector Comment						
Tree stump on landside slope should be removed

View of tree stump on landside slope. (Fall 2018)

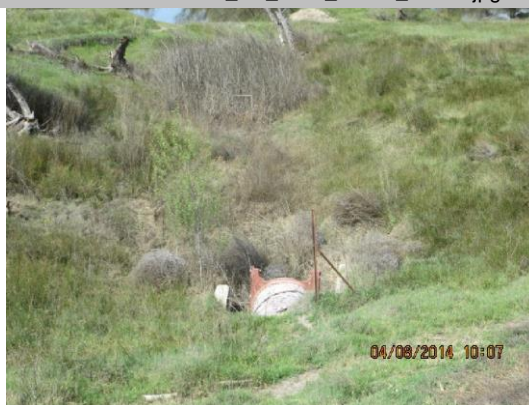
Photo 1 of 3 : UCIP_SP_2019_39125_71309.jpg

LM Start	2.22	Rating **	A/W	Issue No.	1197
LM End	2.22	Issue Type +	Ma	Location *	
Category	Supplemental			GPS Latitude/Longitude	
				Start	End
Item	DWR UCIP LMA Responsibility			37.331611 °	37.331611 °
				-120.937455 °	-120.937455 °
DWR ID	19571				
Comment Code					
Inspector Comment					
FS_ID:39125					
DS_ID:19571					
EP_NO: N/A					
Repair Type: No Action Needed					
Crossing Status: Found					
UCIP Comments:					
FIELD_STRUCT_DESC: 36-inch corrugated metal gravity drainage pipe through the levee, 12.6 feet below the crown. Flap gate on the waterside (WS) end. Brass cap No. 100 bench mark (BM) on the headwall on the landside (LS). Wooden barrier around drop inlet on the LS toe. [Additional Reference(s): DWR Levee Log, 2002. USACE San Joaquin O&M Manual 601.1, 1967, (HLM 2.25)].					
FS Date: 4/8/2014

Pipe and flapgate on WS toe.

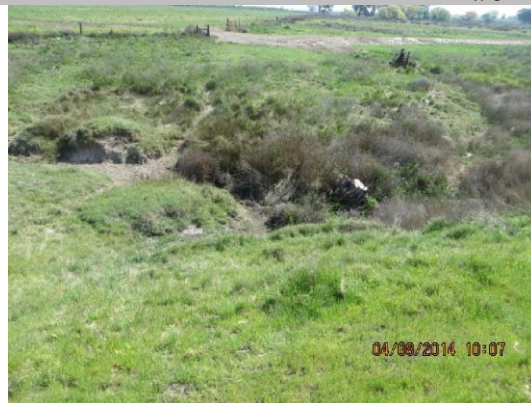
Photo 2 of 3 : UCIP_SP_2019_39125_71308.jpg

Pipe and headwall on LS toe.

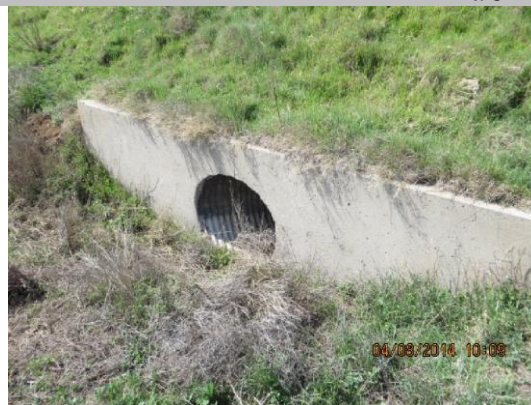
Photo 3 of 3 : UCIP_SP_2019_39125_71307.jpg

Pipe and headwall on LS toe.

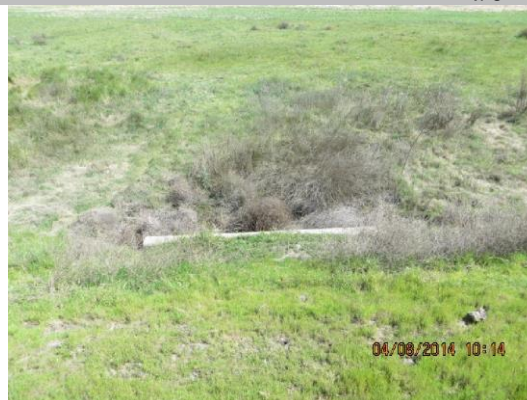
Photo 3 of 3 : UCIP_SP_2019_33568_60678.jpg

Pipe and headwall on LS toe.

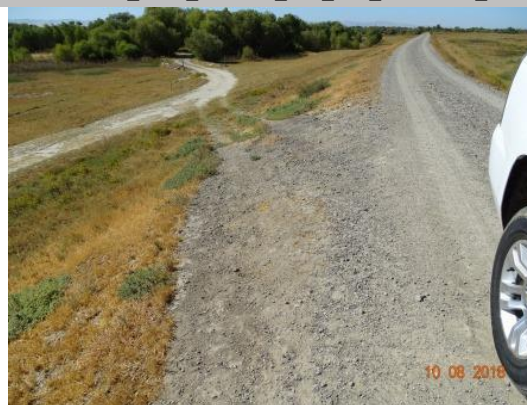
Photo 1 of 1 : SP_2019_NA0010_118_113_20190307_00031.jpg

LM Start	2.58	Rating **	A/W	Issue No.	113
LM End	2.58	Issue Type +	Ma	Location *	WS
Category	Earthen Levee			GPS Latitude/Longitude	
				Start	End
Item	Slope Stability			37.327936 °	37.327936 °
				-120.933013 °	-120.933013 °
DWR ID	DWR_NA0010_01_f_2018_113				
Comment Code					
S3 : Repair the levee slope damaged by vehicle traffic and prevent access where possible.					
Inspector Comment					
damage caused by vehicle traffic over the levee.

Erosion caused by vehicle traffic. (Fall 2018)

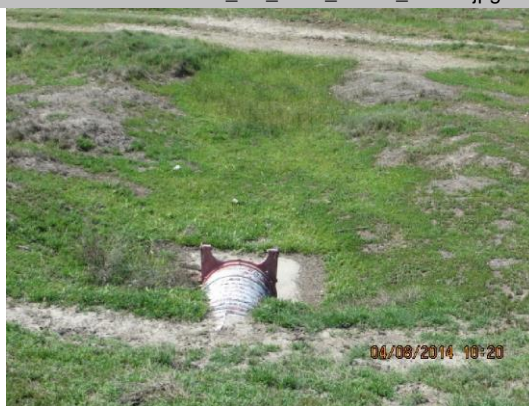
Photo 1 of 3 : UCIP_SP_2019_39127_60688.jpg

LM Start	2.67	Rating **	M	Issue No.	1199
LM End	2.67	Issue Type +	Ma	Location *	
Category	Supplemental			GPS Latitude/Longitude	
				Start	End
Item	DWR UCIP LMA Responsibility			37.327362 °	37.327362 °
				-120.931591 °	-120.931591 °
DWR ID	19573				
Comment Code					
Inspector Comment					
FS_ID:39127 DS_ID:19573 EP_NO: N/A Repair Type: Non-Urgent Crossing Status: Found UCIP Comments: 04/08/2014 Sedimentation in pipe at landward toe. (DWR UCIP - W. Wylie) FIELD_STRUCT_DESC: 24-inch corrugated metal gravity drainage pipe through the levee, 7.3 feet below the crown. Flap gate on the waterside (WS) end. Brass cap No. 100 bench mark (BM) on the headwall on the landside (LS). [Additional Reference(s): DWR Levee Log, 2002. USACE San Joaquin O&M Manual 601.1, 1967, (HLM 2.70)]. FS Date: 4/8/2014

Pipe, flapgate, and headwall on WS toe.

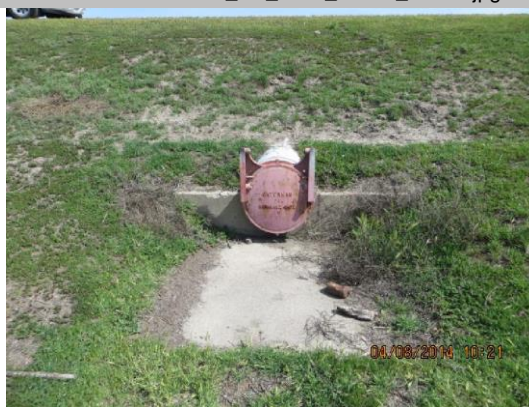
Photo 2 of 3 : UCIP_SP_2019_39127_60689.jpg

Pipe, flapgate, and headwall on WS toe.

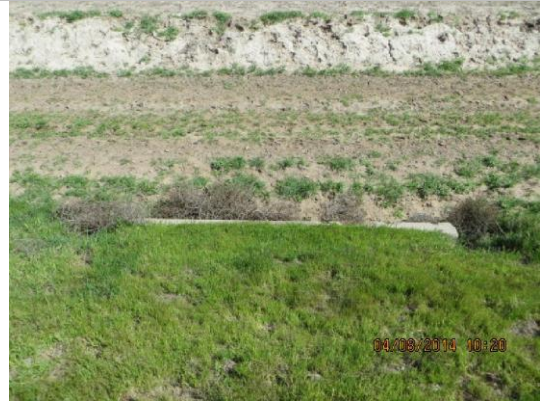
Photo 3 of 3 : UCIP_SP_2019_39127_60687.jpg

Pipe and headwall on LS toe.

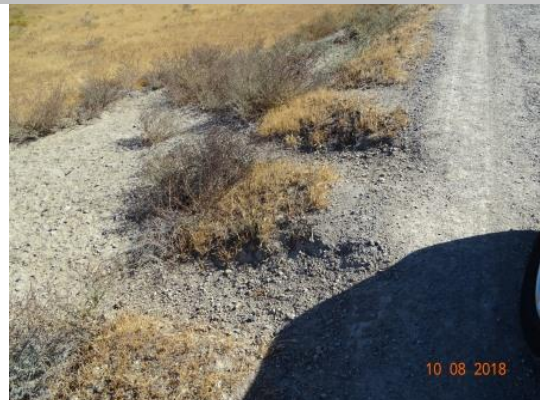
Photo 1 of 1 : SP_2019_NA0010_118_114_20190307_00032.jpg

LM Start	2.99	Rating **	M	Issue No.	114
LM End	2.99	Issue Type +	Ma	Location *	LS
Category	Earthen Levee			GPS Latitude/Longitude	
				Start	End
Item	Slope Stability			37.323328 °	37.323328 °
				-120.929521 °	-120.929521 °
DWR ID	DWR_NA0010_01_f_2018_114				
Comment Code					
S2 : Repair the levee slope damaged by foot traffic and prevent access where possible.					
Inspector Comment					
Slope damage caused by livestock.

View of slope damage caused by livestock. (Fall 2018)

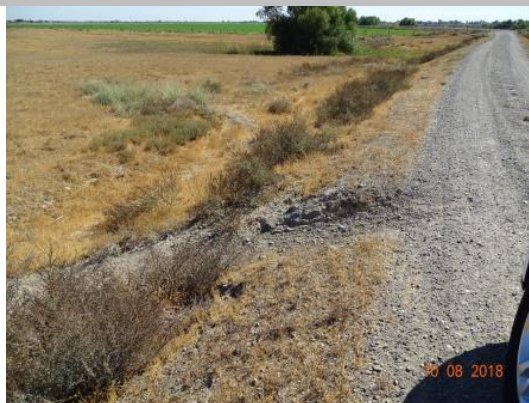
Photo 1 of 2 : SP_2019_NA0010_118_115_20190307_00033.jpg

LM Start	3.10	Rating **	M	Issue No.	115
LM End	3.10	Issue Type +	Ma	Location *	LS
Category	Earthen Levee			GPS Latitude/Longitude	
				Start	End
Item	Slope Stability			37.321903 °	37.321903 °
				-120.928748 °	-120.928748 °
DWR ID	DWR_NA0010_01_f_2018_115				
Comment Code					
S2 : Repair the levee slope damaged by foot traffic and prevent access where possible.					
Inspector Comment					
Damage caused by foot traffic.

View of erosion path looking downstream. (Fall 2018)

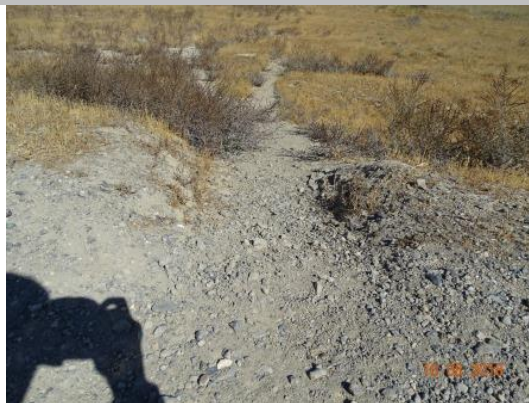
Photo 2 of 2 : SP_2019_NA0010_118_115_20190307_00034.jpg

View of erosion path looking down landside slope. (Fall 2018)

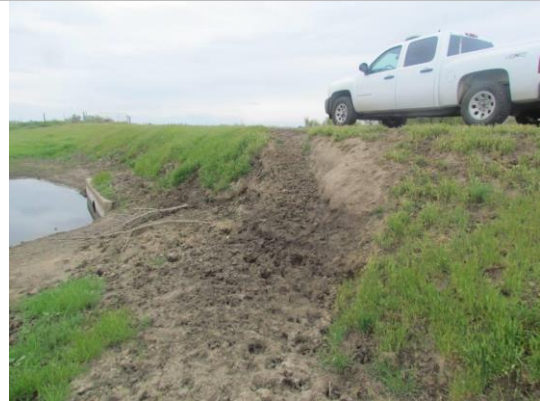
Photo 1 of 1 : SP_2019_NA0010_118_108_20190307_00023.jpg

LM Start	3.11	Rating **	M	Issue No.	108
LM End	3.11	Issue Type +	Ma	Location *	LS
Category	Earthen Levee			GPS Latitude/Longitude	
				Start	End
Item	Slope Stability			37.321704 °	37.321704 °
				-120.928749 °	-120.928749 °
DWR ID	DWR_NA0010_01_s_2017_108				
Comment Code					
S2 : Repair the levee slope damaged by foot traffic and prevent access where possible.					
Inspector Comment					
Slope damage caused by animal traffic on landside toe.

Looking west at slope damage caused by animal traffic.

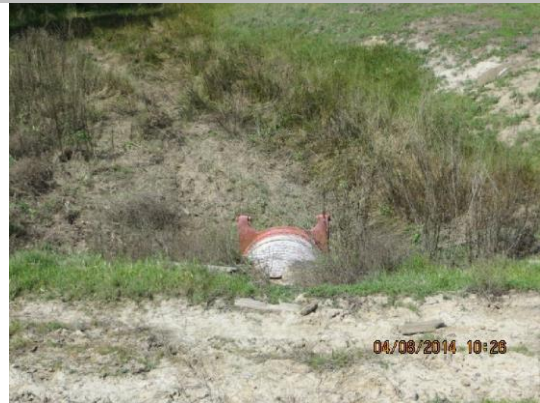
Photo 1 of 3 : UCIP_SP_2019_39128_60702.jpg

LM Start	3.13	Rating **	M	Issue No.	1200
LM End	3.13	Issue Type +	Ma	Location *	
Category	Supplemental			GPS Latitude/Longitude	
				Start	End
Item	DWR UCIP LMA Responsibility			37.321444 °	37.321444 °
				-120.928764 °	-120.928764 °
DWR ID	19574				
Comment Code					
Inspector Comment					
FS_ID:39128 DS_ID:19574 EP_NO: N/A Repair Type: Non-Urgent Crossing Status: Found UCIP Comments: 04/08/2014 Some minor erosion around headwall on LS toe. (DWR UCIP - W. Wylie) FIELD_STRUCT_DESC: 36-inch corrugated metal gravity drainage pipe through the levee, 8 feet below the crown. Flap gate on the waterside (WS) end. Brass cap No. 100 bench mark (BM) on the headwall on the landside (LS). [Additional Reference(s): DWR Levee Log, 2002. USACE San Joaquin O&M Manual 601.1, 1967, (HLM 3.16)]. FS Date: 4/8/2014

Pipe, Flapgate, and headwall on WS toe.

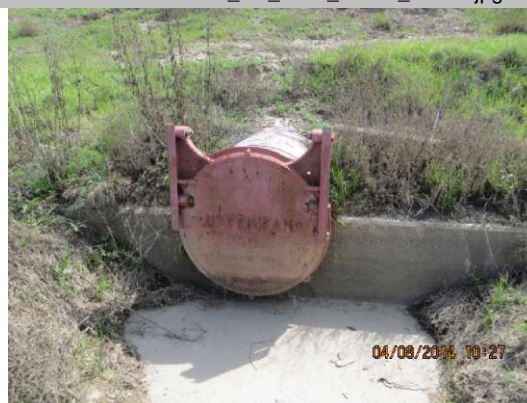
Photo 2 of 3 : UCIP_SP_2019_39128_60700.jpg

Pipe, Flapgate, and headwall on WS toe.

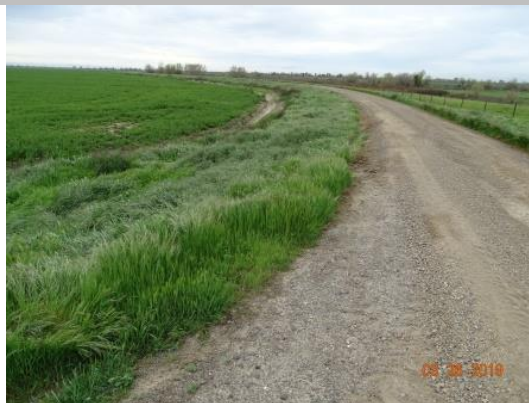
Photo 1 of 1 : SP_2019_NA0010_118_98_20190402_00284.jpg

LM Start	3.16	Rating **	M	Issue No.	98
LM End	3.97	Issue Type +	Ma	Location *	LS
Category	Earthen Levee			GPS Latitude/Longitude	
				Start	End
Item	Vegetation			37.321061 °	37.310887 °
				-120.928808 °	-120.926251 °
DWR ID	DWR_NA0010_01_s_2019_98				
Comment Code					
V1 : Control annual grass and weeds on the levee slopes and easements.					
Inspector Comment

View of landside slope looking upstream. (Spring 2019)

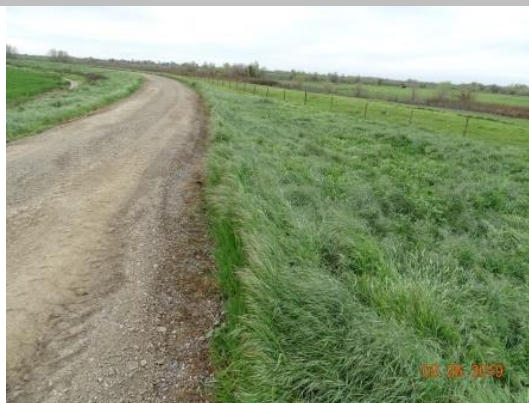
Photo 1 of 1 : SP_2019_NA0010_118_99_20190402_00285.jpg

LM Start	3.16	Rating **	M	Issue No.	99
LM End	8.53	Issue Type +	Ma	Location *	WS
Category	Earthen Levee			GPS Latitude/Longitude	
				Start	End
Item	Vegetation			37.321061 °	37.296420 °
				-120.928808 °	-120.859409 °
DWR ID	DWR_NA0010_01_s_2019_99				
Comment Code					
V1 : Control annual grass and weeds on the levee slopes and easements.					
Inspector Comment

View of waterside slope looking upstream. (Spring 2019)

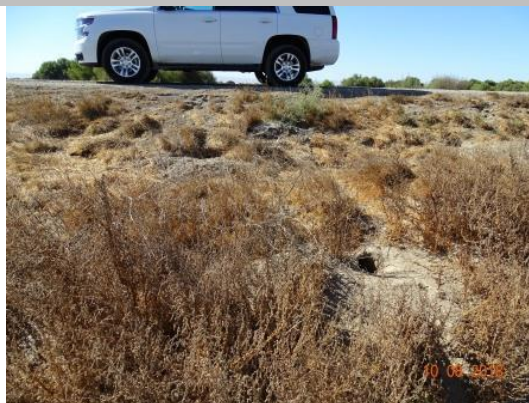
Photo 1 of 2 : SP_2019_NA0010_118_116_20190307_00035.jpg

LM Start	3.18	Rating **	M	Issue No.	116
LM End	3.18	Issue Type +	Ma	Location *	LS
Category	Earthen Levee			GPS Latitude/Longitude	
				Start	End
Item	Animal Control			37.320725 °	37.320725 °
				-120.928837 °	-120.928837 °
DWR ID	DWR_NA0010_01_f_2018_116				
Comment Code					
A3 : No rodents visible, but rodent burrows visible; need to backfill and compact or grout burrows.					
Inspector Comment					
Several rodent holes noted in this section.

View of landside slope with rodent holes. (Fall 2018)

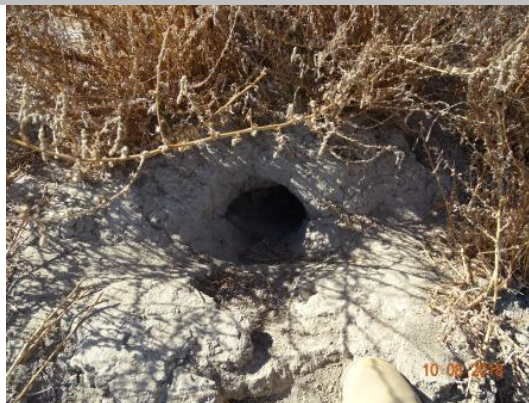
Photo 2 of 2 : SP_2019_NA0010_118_116_20190307_00036.jpg

Representative view of rodent holes in this section. (Fall 2018)

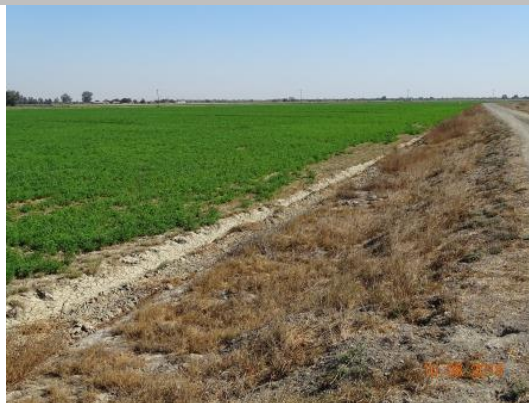
Photo 1 of 1 : SP_2019_NA0010_118_117_20190307_00037.jpg

LM Start	3.23	Rating **	M	Issue No.	117
LM End	3.90	Issue Type +	En	Location *	LS
Category	Earthen Levee			GPS Latitude/Longitude	
				Start	End
Item	Encroachments			37.320029 °	37.311311 °
				-120.928556 °	-120.927310 °
DWR ID	DWR_NA0010_01_f_2018_117				
Comment Code					
DT : Ditch					
Inspector Comment					
Earthen ditch along landside toe.

Earthen ditch along landside toe. (Fall 2018)

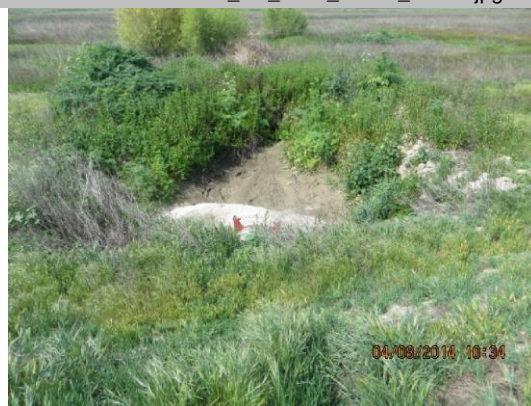
Photo 1 of 3 : UCIP_SP_2019_53188_60707.jpg

Comment Code						
Inspector Comment						
FS_ID:53188 DS_ID:19575 EP_NO: N/A Repair Type: Urgent Crossing Status: Found UCIP Comments: 11/01/2018 Pipe continues to rust through, causing the pipe to collapse on the LS. Sediment buildup visible from the LS inlet. Loss of soil just above the LS concrete headwall and along the LS slope. Crossing remains Urgent due to the levee slope issues and pipe failure through the levee. (O. Magana - DWR UCIP)07/19/2016 Same as previous inspection. Erosion present on LS slope. (DWR UCIP - O. Magana)04/08/2014 Pipe rusted through at Springline on LS toe. Flapgate blocked by sediment on WS toe. Heavy sediment on both ends of pipe. Need to contact owner to address issues. (DWR UCIP - W. Wylie) FIELD_STRUCT_DESC: 36-inch corrugated metal gravity drainage pipe through the levee, 9.7 feet below the crown. Flap gate on the waterside (WS) end. Brass cap No. 100 bench mark (BM) on the headwall on the landside (LS). [Additional Reference(s): DWR Levee Log, 2002. USACE San Joaquin O&M Manual 601.1, 1967, (HLM 3.50)]. FS Date: 11/1/2018 12:49:00 PM

Pipe, headwall, and flapgate on WS toe.

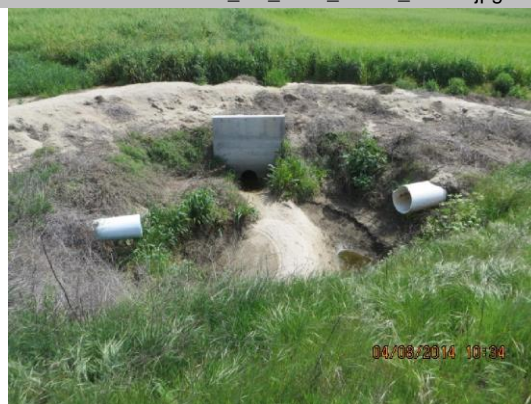
Photo 2 of 3 : UCIP_SP_2019_53188_60706.jpg

Pipe and headwall on LS toe.

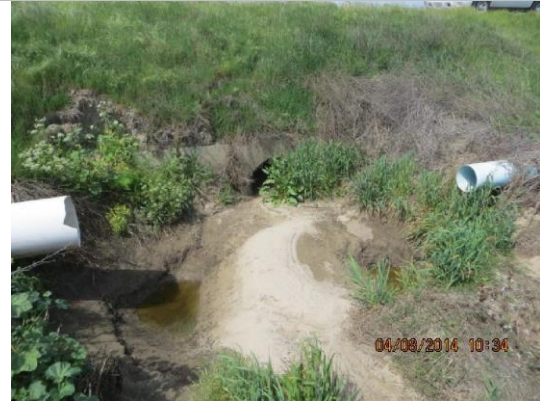
Photo 3 of 3 : UCIP_SP_2019_53188_60705.jpg

Comment Code						
Inspector Comment						
FS_ID:53188 DS_ID:19575 EP_NO: N/A Repair Type: Urgent Crossing Status: Found UCIP Comments: 11/01/2018 Pipe continues to rust through, causing the pipe to collapse on the LS. Sediment buildup visible from the LS inlet. Loss of soil just above the LS concrete headwall and along the LS slope. Crossing remains Urgent due to the levee slope issues and pipe failure through the levee. (O. Magana - DWR UCIP)07/19/2016 Same as previous inspection. Erosion present on LS slope. (DWR UCIP - O. Magana)04/08/2014 Pipe rusted through at Springline on LS toe. Flapgate blocked by sediment on WS toe. Heavy sediment on both ends of pipe. Need to contact owner to address issues. (DWR UCIP - W. Wylie) FIELD_STRUCT_DESC: 36-inch corrugated metal gravity drainage pipe through the levee, 9.7 feet below the crown. Flap gate on the waterside (WS) end. Brass cap No. 100 bench mark (BM) on the headwall on the landside (LS). [Additional Reference(s): DWR Levee Log, 2002. USACE San Joaquin O&M Manual 601.1, 1967, (HLM 3.50)]. FS Date: 11/1/2018 12:49:00 PM

Pipe and headwall on LS toe.

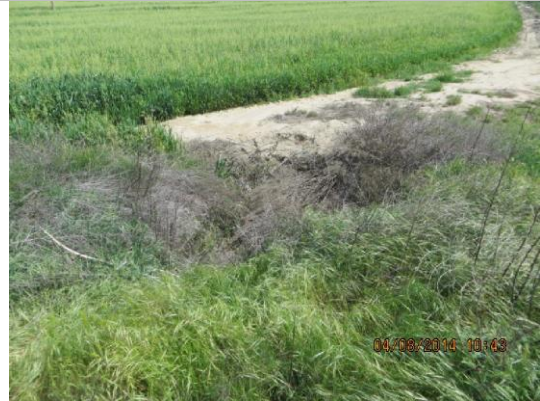
Photo 3 of 3 : UCIP_SP_2019_39132_60722.jpg

Comment Code					
Inspector Comment					
FS_ID:39132 DS_ID:19576 EP_NO: N/A Repair Type: Non-Urgent Crossing Status: Found UCIP Comments: 04/08/2014 Slide gate missing from WS. No closure device, but degrading of levee at Highway 140 is lower than pipe, so this does not appear to be a critical issue. Also dense vegetation limits the inspector's visibility to identify signs of pipe failure (leaks) along the slope. Recommend removing vegetation along pipe alignment to conduct proper inspection of structure and appurtenances. (DWR UCIP - W. Wylie) FIELD_STRUCT_DESC: 30-inch corrugated metal gravity drainage pipe through the levee, 3.5 feet below the crown. Flap gate on the waterside (WS) end. Brass cap No. 100 bench mark (BM) on the headwall on the landside (LS). [Additional Reference(s): DWR Levee Log, 2002. USACE San Joaquin O&M Manual 601.1, 1967, (HLM 3.95)]. FS Date: 4/8/2014

Concrete headwall in heavy vegetation at LS toe.

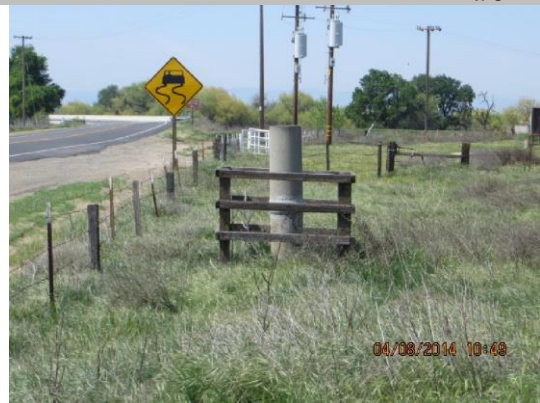
Photo 1 of 2 : UCIP_SP_2019_39133_60725.jpg

LM Start	3.93	Rating **	M	Issue No.	1203
LM End	3.93	Issue Type +	En	Location *	
Category	Supplemental			GPS Latitude/Longitude	
				Start	End
Item	DWR UCIP Field Study			37.311157 °	37.311157 °
				-120.926919 °	-120.926919 °
DWR ID	19606				
Comment Code					
Inspector Comment					
FS_ID:39133					
DS_ID:19606					
EP_NO: N/A					
Repair Type: Non-Urgent					
Crossing Status: Indicator Found					
UCIP Comments: 04/08/2014 Need to contact owner to determine status of crossing inlet and outlet not found. (DWR UCIP - W. Wylie)					
FIELD_STRUCT_DESC: 12-inch reinforced concrete irrigation discharge pipe through the levee, 3.5 feet below the crown. 12-inch concrete standpipe off each side of the levee. [Additional Reference(s): DWR Levee Log, 2002].					
FS Date: 4/8/2014

12-inch concrete standpipe off WS toe.

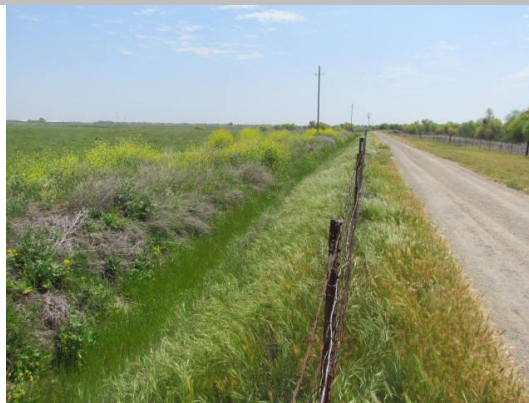
Photo 2 of 2 : SP_2019_NA0010_118_5_20190307_00003.jpg

LM Start	3.98	Rating **	U	Issue No.	5 (cont)	
LM End	4.05	Issue Type +	En	Location *	LS	
Category	Earthen Levee			GPS Latitude/Longitude		
				Start		End
Item	Encroachments			37.310837 °	37.310003 °	
				-120.926182 °	-120.925313 °	
DWR ID	DWR_NA0010_01_s_2012_5					
Comment Code						
DT : Ditch						
Inspector Comment						
Irrigation ditch at landside toe

Looking south at irrigation ditch at landside toe.

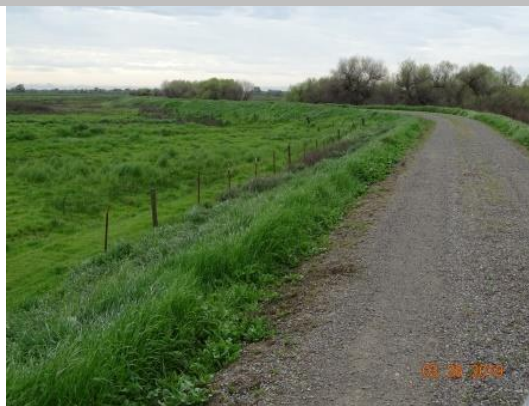
Photo 1 of 1 : SP_2019_NA0010_118_100_20190402_00286.jpg

LM Start	4.09	Rating **	M	Issue No.	100
LM End	7.81	Issue Type +	Ma	Location *	LS
Category	Earthen Levee			GPS Latitude/Longitude	
				Start	End
Item	Vegetation			37.309601 °	37.298553 °
				-120.924897 °	-120.871703 °
DWR ID	DWR_NA0010_01_s_2019_100				
Comment Code					
V1 : Control annual grass and weeds on the levee slopes and easements.					
Inspector Comment

View of vegetation on landside slope looking upstream. (Spring 2019)

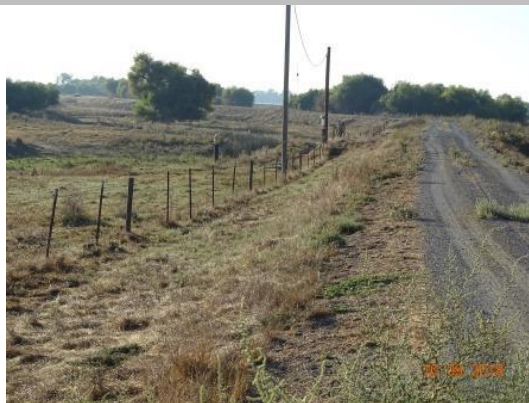
Photo 1 of 1 : SP_2019_NA0010_118_118_20190307_00038.jpg

LM Start	4.12	Rating **	U	Issue No.	118
LM End	4.15	Issue Type +	En	Location *	LS
Category	Earthen Levee			GPS Latitude/Longitude	
				Start	End
Item	Encroachments			37.309225 °	37.308817 °
				-120.924589 °	-120.924247 °
DWR ID	DWR_NA0010_01_f_2018_118				
Comment Code					
FE : Fence					
Inspector Comment					
Fence along landside toe.

View of fence along landside toe. (Fall 2018)

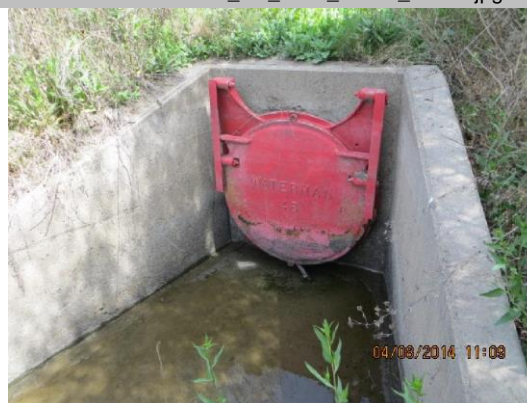
Photo 1 of 3 : UCIP_SP_2019_39134_60730.jpg

Comment Code						
Inspector Comment						
FS_ID:39134 DS_ID:19607 EP_NO: N/A Repair Type: Non-Urgent Crossing Status: Found UCIP Comments: 04/08/2014 Pipe appears sleeved with a 12-inch steel pipe with a slide gate at the LS toe. No identified authorization for changes to this crossing. Need to contact owner to obtain additional information about the modifications to crossing. (DWR UCIP - W. Wylie) FIELD_STRUCT_DESC: 48-inch corrugated metal gravity drainage pipe through the levee, 14 feet below the crown. Flap gate on the waterside (WS) end. Brass cap No. 90 bench mark (BM) on the headwall on the landside (LS). [Additional Reference(s): DWR Levee Log, 2002. USACE San Joaquin O&M Manual 601.1, 1967, (HLM 4.16)]. FS Date: 4/8/2014

Concrete headwall and 48-inch flapgate visible on WS toe.

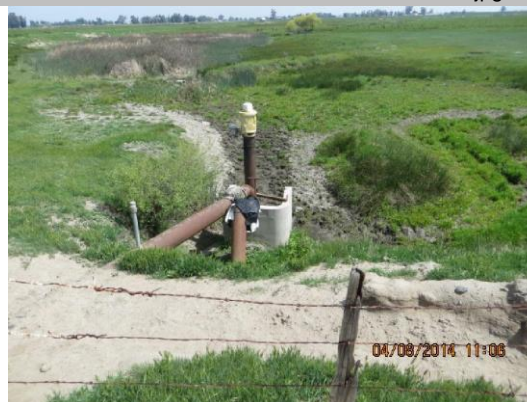
Photo 2 of 3 : UCIP_SP_2019_39134_60731.jpg

Assumed pipe exists under pump at LS toe.

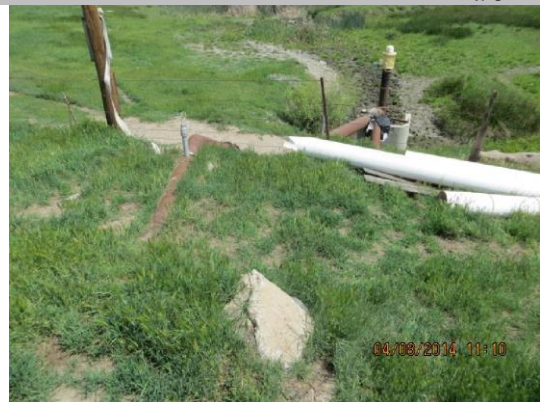
Photo 1 of 2 : UCIP_SP_2019_39138_71320.jpg

LM Start	4.13	Rating **	M	Issue No.	1205	
LM End	4.13	Issue Type +	En	Location *		
Category	Supplemental			GPS Latitude/Longitude		
				Start	End	
Item	DWR UCIP Field Study			37.309063 °	37.309063 °	
				-120.924449 °	-120.924449 °	
DWR ID	24866					
Comment Code						
Inspector Comment						
FS_ID:39138 DS_ID:24866 EP_NO: N/A Repair Type: Non-Urgent Crossing Status: Found UCIP Comments: 04/08/2014 Need to contact owner to get details of crossing. (DWR UCIP - W. Wylie) FIELD_STRUCT_DESC: 12-inch steel drainage discharge pipe through the levee, 2.5 feet below the crown. 12-inch steel pipe, vent, and pump on stand visible on the landside (LS) slope. 10-inch polyvinyl chloride (PVC) pipe visible on the waterside (WS) slope. FS Date: 4/8/2014

View of pipe visible on landward side.

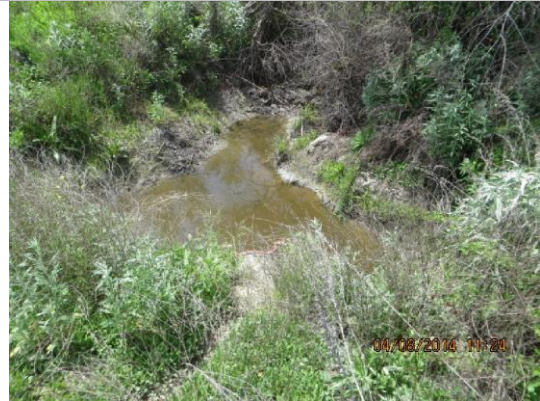
Photo 1 of 3 : UCIP_SP_2019_39140_60733.jpg

Comment Code						
Inspector Comment						
FS_ID:39140 DS_ID:19608 EP_NO: N/A Repair Type: Non-Urgent Crossing Status: Found UCIP Comments: 04/08/2014 Dense vegetation and fence limits the inspector's visibility to identify signs of pipe failure (leaks) along the landward side. Recommend obtaining access to landward toe and removing vegetation along pipe alignment to conduct proper inspection of structure and appurtenances. (DWR UCIP - W. Wylie) FIELD_STRUCT_DESC: 24-inch corrugated metal gravity drainage pipe through the levee, 11.9 feet below the crown. Flap gate on the waterside (WS) end. Brass cap No. 90 bench mark (BM) on the headwall on the landside (LS). [Additional Reference(s): DWR Levee Log, 2002. USACE San Joaquin O&M Manual 601.1, 1967, (HLM 4.27)]. FS Date: 4/8/2014

Pipe, flapgate, and headwall visible at WS toe.

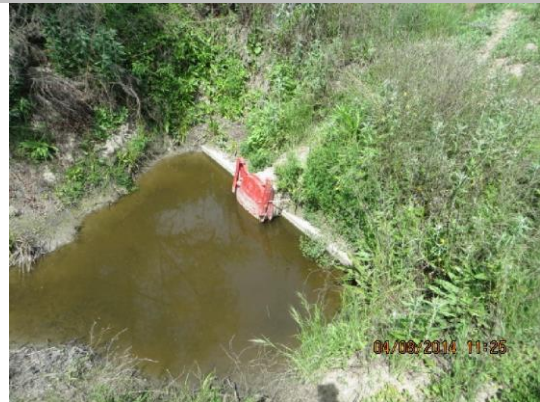
Photo 2 of 3 : UCIP_SP_2019_39140_60732.jpg

Pipe, flapgate, and headwall visible at WS toe.

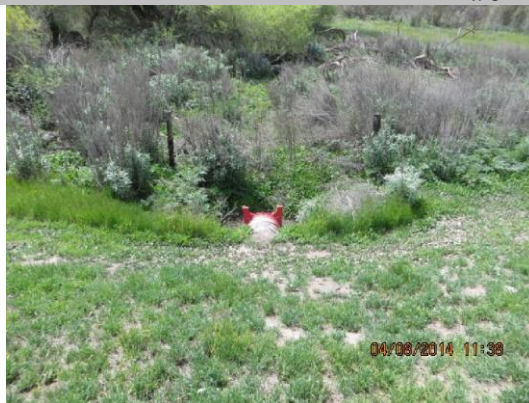
Photo 1 of 2 : UCIP_SP_2019_39143_60740.jpg

LM Start	5.02	Rating **	M	Issue No.	1208	
LM End	5.02	Issue Type +	Ma	Location *		
Category	Supplemental			GPS Latitude/Longitude		
				Start		End
Item	DWR UCIP LMA Responsibility			37.298917 °		37.298917 °
				-120.917262 °		-120.917262 °
DWR ID	19610					
Comment Code						
Inspector Comment						
FS_ID:39143 DS_ID:19610 EP_NO: N/A Repair Type: Non-Urgent Crossing Status: Found UCIP Comments: 04/08/2014 Non-functional -- sediment buildup against flapgate and inlet buried at landward side. (DWR UCIP - W. Wylie) FIELD_STRUCT_DESC: 24-inch corrugated metal gravity drainage pipe through the levee, 8 feet below the crown. Flap gate on the waterside (WS) end. Brass cap No. 90 bench mark (BM) on the headwall on the landside (LS). [Additional Reference(s): DWR Levee Log, 2002. USACE San Joaquin O&M Manual 601.1, 1967, (HLM 5.05)]. FS Date: 4/8/2014

Flapgate and headwall visible at WS toe.

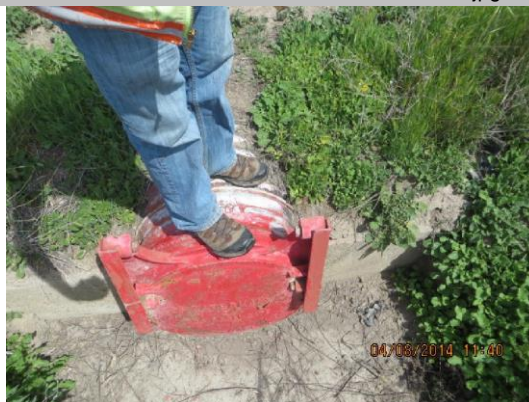
Photo 2 of 2 : UCIP_SP_2019_39143_60739.jpg

Flapgate and headwall visible at WS toe.

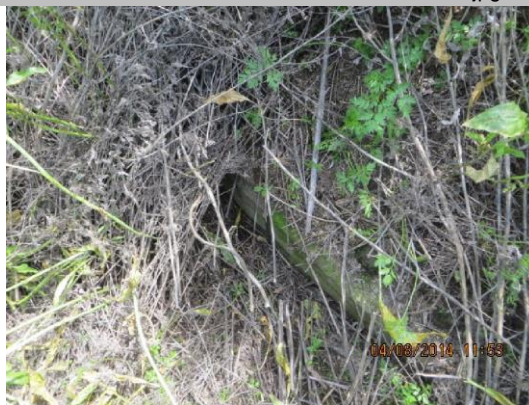
Photo 2 of 2 : UCIP_SP_2019_39151_60741.jpg

FS_ID:39151
DS_ID:19611
EP_NO: N/A
Repair Type: Non-Urgent
Crossing Status: Found
UCIP Comments: 04/08/2014 Dense vegetation limits the inspector's visibility to identify signs of pipe failure (leaks) along waterward and landward slopes. Recommend removing vegetation along pipe alignment to conduct proper inspection of structure and appurtenances. Landward side filled in with soil. Need to contact owner. If crossing is no longer used need to coordinate with CVFPB for proper abandonment. (DWR UCIP - W. Wylie)
FIELD_STRUCT_DESC: 24-inch corrugated metal gravity drainage pipe through the levee, 8.6 feet below the crown. Flap gate on the waterside (WS) end. Brass cap No. 90 bench mark (BM) on the headwall on the landside (LS). [Additional Reference(s): DWR Levee Log, 2002. USACE San Joaquin O&M Manual 601.1, 1967, (HLM 5.95)].
FS Date: 4/8/2014

Top of concrete headwall just visible on LS toe.

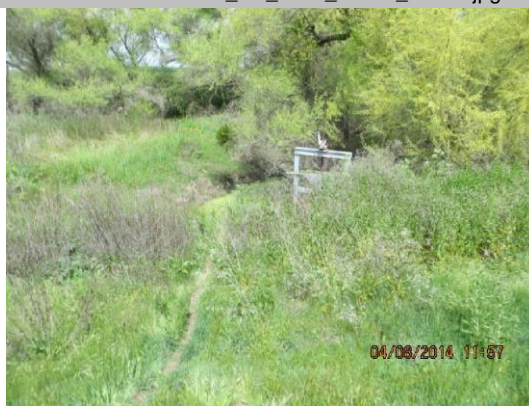
Photo 1 of 3 : UCIP_SP_2019_39152_60745.jpg

Comment Code						
Inspector Comment						
FS_ID:39152 DS_ID:19612 EP_NO: N/A Repair Type: Non-Urgent Crossing Status: Found UCIP Comments: 04/08/2014 Dense vegetation limits the inspector's visibility to identify signs of pipe failure (leaks) along waterward and landward slopes. Recommend removing vegetation along pipe alignment to conduct proper inspection of structure and appurtenances. Pipe completely blocked by soil on LS toe due to animal activity. Slide gate blocked open. (DWR UCIP - W. Wylie) FIELD_STRUCT_DESC: 48-inch corrugated metal gravity drainage pipe through the levee, 13.1 feet below the crown. Walkway to slide gate at the concrete headwall on the landside (LS) toe. Flap gate at the concrete headwall on the waterside (WS) toe. Brass cap No. 90 bench mark (BM) on the headwall on the LS. Pipe crosses the levee at an angle. [Additional Reference(s): DWR Levee Log, 2002. USACE San Joaquin O&M Manual 601.1, 1967, (HLM 6.13)]. FS Date: 4/8/2014

Slidegate at LS toe.

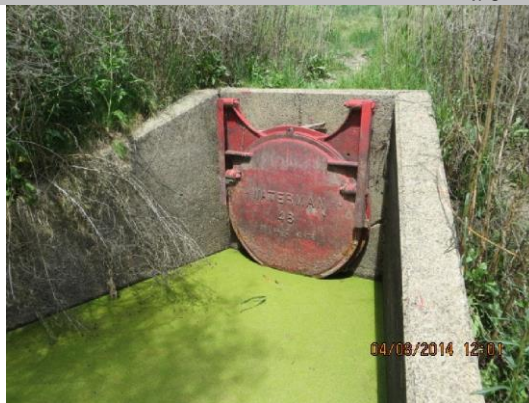
Photo 3 of 3 : UCIP_SP_2019_39152_60743.jpg

Comment Code						
Inspector Comment						
FS_ID:39152 DS_ID:19612 EP_NO: N/A Repair Type: Non-Urgent Crossing Status: Found UCIP Comments: 04/08/2014 Dense vegetation limits the inspector's visibility to identify signs of pipe failure (leaks) along waterward and landward slopes. Recommend removing vegetation along pipe alignment to conduct proper inspection of structure and appurtenances. Pipe completely blocked by soil on LS toe due to animal activity. Slide gate blocked open. (DWR UCIP - W. Wylie) FIELD_STRUCT_DESC: 48-inch corrugated metal gravity drainage pipe through the levee, 13.1 feet below the crown. Walkway to slide gate at the concrete headwall on the landside (LS) toe. Flap gate at the concrete headwall on the waterside (WS) toe. Brass cap No. 90 bench mark (BM) on the headwall on the LS. Pipe crosses the levee at an angle. [Additional Reference(s): DWR Levee Log, 2002. USACE San Joaquin O&M Manual 601.1, 1967, (HLM 6.13)]. FS Date: 4/8/2014

Flapgate on concrete headwall at WS toe.

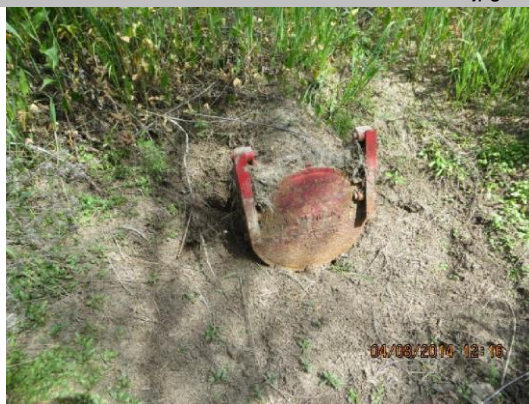
Photo 2 of 3 : UCIP_SP_2019_49962_60766.jpg

Comment Code					
Inspector Comment					
FS_ID:49962 DS_ID:19614 EP_NO: N/A Repair Type: Non-Urgent Crossing Status: Found UCIP Comments: 7/19/2016 Same as previous inspection. Outlet and inlet are under water. (DWR UCIP - O. Magana)4/08/2014 Flapgate blocked by sedimentation at WS toe. Dense vegetation limits the inspector's visibility to identify signs of pipe failure (leaks) along the slope. Recommend removing vegetation along pipe alignment to conduct proper inspection of structure and appurtenances. Also recommend clearing vegetation from both waterward and landward toe. (DWR UCIP - W. Wylie) FIELD_STRUCT_DESC: 24-inch corrugated metal gravity drainage pipe through the levee, 9.8 feet below the crown. Wooden fence around a 4-foot by 4-foot drop inlet on the landside (LS) toe. Flap gate on the waterside (WS) end. Brass cap No. 90 bench mark (BM) on the headwall on the LS. [Additional Reference(s): DWR Levee Log, 2002. USACE San Joaquin O&M Manual 601.1, 1967, (HLM 6.64)]. FS Date: 7/19/2016

Pipe and flapgate visible at WS toe. Flapgate blocked by sedimentation on WS toe.

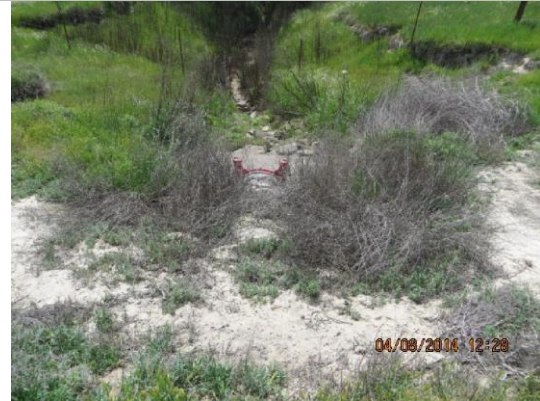
Photo 1 of 3 : UCIP_SP_2019_53412_60770.jpg

Comment Code						
Inspector Comment						
FS_ID:53412						
DS_ID:19616						
EP_NO: N/A						
Repair Type: Urgent						
Crossing Status: Found						
UCIP Comments: 11/01/2018 Pipe continues to corrode through. Voids (undermining) along pipe invert are visible from the LS. Potential undermining caused by erosion under concrete apron on the WS. Crossing remains Urgent due to the pipe failure. (O. Magana - DWR UCIP)04/08/2014 Pipe failing and corroded through at LS toe. Need to contact owner to determine status of crossing. Also dense vegetation limits the inspector's visibility to identify signs of pipe failure (leaks) along the landward slope. Recommend removing vegetation along pipe alignment to conduct proper inspection of structure. (DWR UCIP - W. Wylie)						
FIELD_STRUCT_DESC: 24-inch corrugated metal gravity drainage pipe through the levee, 5.1 feet below the crown. Flap gate on the waterside (WS) end. Brass cap No. 90 bench mark (BM) on the headwall on the landside (LS). [Additional Reference(s): DWR Levee Log, 2002. USACE San Joaquin O&M Manual 601.1, 1967, (HLM 7.21)].

Pipe, concrete headwall, and flapgate on WS toe.
