**Flood Control Project Maintenance
Levee Inspections**
LMA District Cover Sheet
Spring 2019 Levee Inspection Results

Lower San Joaquin Levee District

Spring 2019 Levee Inspection Results

Waterway			Bank	Unit Miles
Unit No. 01 San Joaquin River			Right	22.52
	Spring (March - May)	Summer (June - August)	(September - November) Fall	Winter (December - February)
Unit Maintenance Rating (Fall Only)				
Date of Inspection	3/26/2019 - 3/26/2019			
DWR Inspector	Corey Fujitani			
Accompanied By

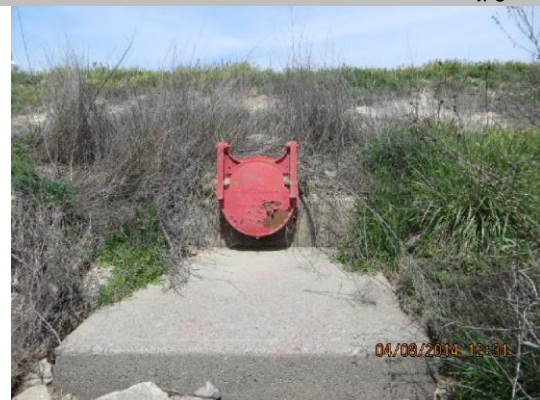
Photo 2 of 3 : UCIP_SP_2019_53412_60772.jpg

Comment Code						
Inspector Comment						
FS_ID:53412						
DS_ID:19616						
EP_NO: N/A						
Repair Type: Urgent						
Crossing Status: Found						
UCIP Comments: 11/01/2018 Pipe continues to corrode through. Voids (undermining) along pipe invert are visible from the LS. Potential undermining caused by erosion under concrete apron on the WS. Crossing remains Urgent due to the pipe failure. (O. Magana - DWR UCIP)04/08/2014 Pipe failing and corroded through at LS toe. Need to contact owner to determine status of crossing. Also dense vegetation limits the inspector's visibility to identify signs of pipe failure (leaks) along the landward slope. Recommend removing vegetation along pipe alignment to conduct proper inspection of structure. (DWR UCIP - W. Wylie)						
FIELD_STRUCT_DESC: 24-inch corrugated metal gravity drainage pipe through the levee, 5.1 feet below the crown. Flap gate on the waterside (WS) end. Brass cap No. 90 bench mark (BM) on the headwall on the landside (LS). [Additional Reference(s): DWR Levee Log, 2002. USACE San Joaquin O&M Manual 601.1, 1967, (HLM 7.21)].

Flapgate and concrete headwall on WS toe.

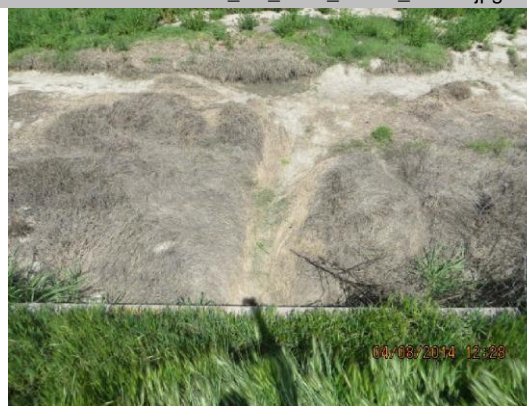
Photo 3 of 3 : UCIP_SP_2019_53412_60771.jpg

Comment Code						
Inspector Comment						
FS_ID:53412 DS_ID:19616 EP_NO: N/A Repair Type: Urgent Crossing Status: Found UCIP Comments: 11/01/2018 Pipe continues to corrode through. Voids (undermining) along pipe invert are visible from the LS. Potential undermining caused by erosion under concrete apron on the WS. Crossing remains Urgent due to the pipe failure. (O. Magana - DWR UCIP)04/08/2014 Pipe failing and corroded through at LS toe. Need to contact owner to determine status of crossing. Also dense vegetation limits the inspector's visibility to identify signs of pipe failure (leaks) along the landward slope. Recommend removing vegetation along pipe alignment to conduct proper inspection of structure. (DWR UCIP - W. Wylie) FIELD_STRUCT_DESC: 24-inch corrugated metal gravity drainage pipe through the levee, 5.1 feet below the crown. Flap gate on the waterside (WS) end. Brass cap No. 90 bench mark (BM) on the headwall on the landside (LS). [Additional Reference(s): DWR Levee Log, 2002. USACE San Joaquin O&M Manual 601.1, 1967, (HLM 7.21)]. FS Date: 11/1/2018 1:02:00 PM

Pipe and Concrete headwall visible on LS toe.

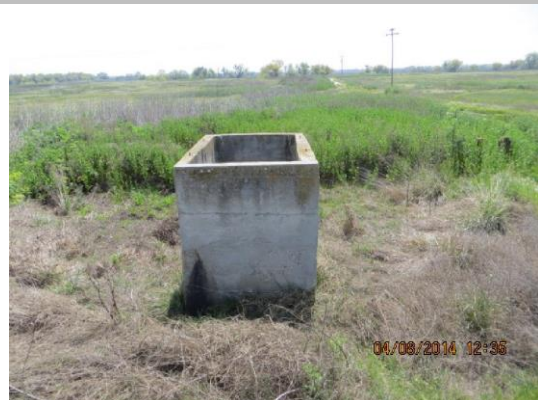
Photo 2 of 3 : UCIP_SP_2019_39160_60775.jpg

Comment Code						
Inspector Comment						
FS_ID:39160 DS_ID:19617 EP_NO: 4425 Repair Type: Non-Urgent Crossing Status: Found UCIP Comments: 04/08/2014 Recommend contacting owner to determine status of crossing. No pump was found on waterward side (riverbank). If crossing is no longer used need to coordinate with CVFPB for proper abandonment. (DWR UCIP - W. Wylie) FIELD_STRUCT_DESC: 24-inch concrete encased steel irrigation discharge pipe through the levee, 13.6 feet below the crown. Pipe encased in 6-inches of concrete through the levee. 5-foot by 7-foot concrete distribution box on the waterside (WS). 20-inch concrete standpipe at the landside (LS) toe. Pump on the riverbank, accessible by walkway platform, pump not found. Concrete cutoff walls around pipe in line with the levee shoulders. Pipe extends to 36-inch concrete pipes on both sides of the levee. (Plans to install an irrigation pipeline through the levee authorized under Permit No. 4425, 1964 - James J. Stevinson, a Corporation). [Additional Reference(s): DWR Levee Log, 2002]. FS Date: 4/8/2014

5'X7' concrete box riser on WS toe.

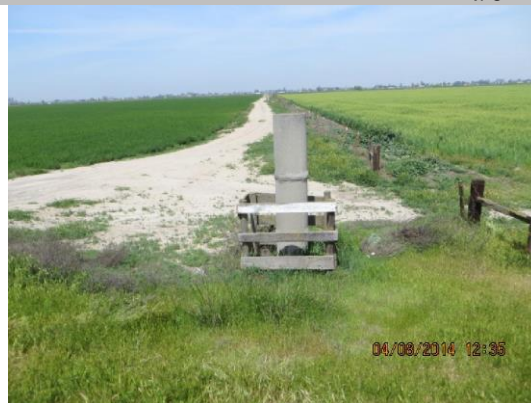
Photo 3 of 3 : UCIP_SP_2019_39160_60774.jpg

Comment Code						
Inspector Comment						
FS_ID:39160 DS_ID:19617 EP_NO: 4425 Repair Type: Non-Urgent Crossing Status: Found UCIP Comments: 04/08/2014 Recommend contacting owner to determine status of crossing. No pump was found on waterward side (riverbank). If crossing is no longer used need to coordinate with CVFPB for proper abandonment. (DWR UCIP - W. Wylie) FIELD_STRUCT_DESC: 24-inch concrete encased steel irrigation discharge pipe through the levee, 13.6 feet below the crown. Pipe encased in 6-inches of concrete through the levee. 5-foot by 7-foot concrete distribution box on the waterside (WS). 20-inch concrete standpipe at the landside (LS) toe. Pump on the riverbank, accessible by walkway platform, pump not found. Concrete cutoff walls around pipe in line with the levee shoulders. Pipe extends to 36-inch concrete pipes on both sides of the levee. (Plans to install an irrigation pipeline through the levee authorized under Permit No. 4425, 1964 - James J. Stevinson, a Corporation). [Additional Reference(s): DWR Levee Log, 2002]. FS Date: 4/8/2014

20-inch concrete standpipe off LS toe.

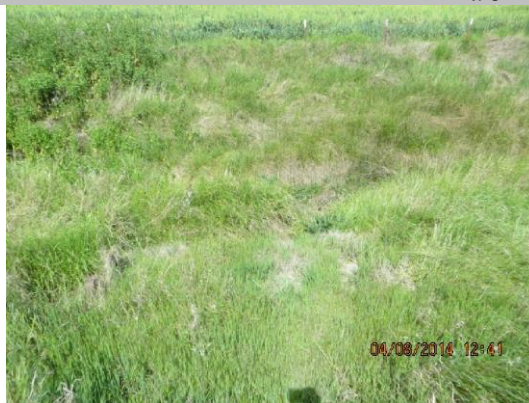
Photo 3 of 3 : UCIP_SP_2019_39161_60779.jpg

Comment Code					
Inspector Comment					
FS_ID:39161 DS_ID:19618 EP_NO: N/A Repair Type: Non-Urgent Crossing Status: Found UCIP Comments: 04/08/2014 Dense vegetation limits the inspector's visibility to identify signs of pipe failure (leaks) along the slope. Recommend removing vegetation along pipe alignment to conduct proper inspection of structure and appurtenances. (DWR UCIP - W. Wylie) FIELD_STRUCT_DESC: 24-inch corrugated metal gravity drainage pipe through the levee, 8 feet below the crown. Flap gate on the waterside (WS) end. Brass cap No. 80 bench mark (BM) on the headwall on the landside (LS). [Additional Reference(s): DWR Levee Log, 2002. USACE San Joaquin O&M Manual 601.1, 1967, (HLM 7.46)]. FS Date: 4/8/2014

Concrete headwall and pipe visible off LS toe in heavy vegetation.

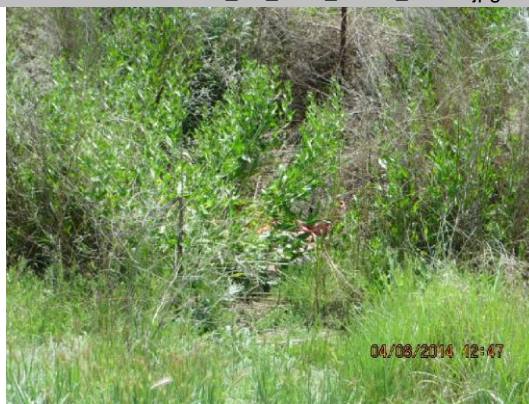
Photo 1 of 3 : UCIP_SP_2019_39243_60842.jpg

Comment Code						
Inspector Comment						
FS_ID:39243 DS_ID:19619 EP_NO: N/A Repair Type: Non-Urgent Crossing Status: Found UCIP Comments: 04/08/2014 Dense vegetation limits the inspector's visibility to identify signs of pipe failure (leaks) along the slope. Recommend removing vegetation along pipe alignment to conduct proper inspection of structure. (DWR UCIP - W. Wylie) FIELD_STRUCT_DESC: 24-inch corrugated metal gravity drainage pipe through the levee, 10 feet below the crown. Flap gate on the waterside (WS) end. Brass cap No. 80 bench mark (BM) on the headwall on the landside (LS). [Additional Reference(s): DWR Levee Log, 2002. USACE San Joaquin O&M Manual 601.1, 1967, (HLM 7.69)]. FS Date: 4/8/2014

Flapgate and headwall at WS toe. Heavy vegetation on slopes.

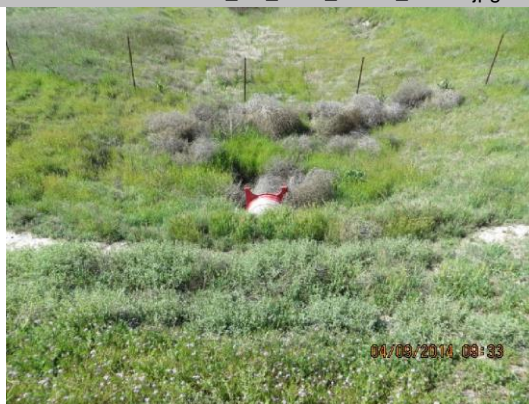
Photo 1 of 3 : UCIP_SP_2019_39245_60850.jpg

Comment Code					
Inspector Comment					
FS_ID:39245					
DS_ID:19621					
EP_NO: N/A					
Repair Type: Non-Urgent					
Crossing Status: Found					
UCIP Comments: 04/09/2014 Dense vegetation limits the inspector's visibility to identify signs of pipe failure (leaks) along the slope.					
Recommend removing vegetation along pipe alignment to conduct proper inspection of structure. Sediment buildup at landward toe. (DWR UCIP - W. Wylie)					
FIELD_STRUCT_DESC: 24-inch corrugated metal gravity drainage pipe through the levee, 9.5 feet below the crown. Flap gate on the waterside (WS) end. Brass cap No. 80 bench mark (BM) on the headwall on the landside (LS). [Additional Reference(s): DWR Levee Log, 2002. USACE San Joaquin O&M Manual 601.1, 1967, (HLM 8.41)].					
FS Date: 4/9/2014

Concrete headwall, pipe, and flapgate at WS toe.

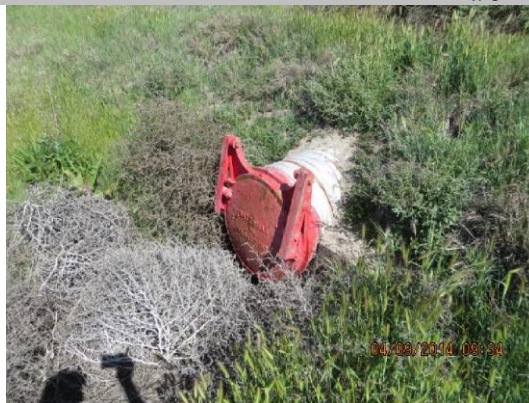
Photo 2 of 3 : UCIP_SP_2019_39245_60848.jpg

Comment Code					
Inspector Comment					
FS_ID:39245 DS_ID:19621 EP_NO: N/A Repair Type: Non-Urgent Crossing Status: Found UCIP Comments: 04/09/2014 Dense vegetation limits the inspector's visibility to identify signs of pipe failure (leaks) along the slope. Recommend removing vegetation along pipe alignment to conduct proper inspection of structure. Sediment buildup at landward toe. (DWR UCIP - W. Wylie) FIELD_STRUCT_DESC: 24-inch corrugated metal gravity drainage pipe through the levee, 9.5 feet below the crown. Flap gate on the waterside (WS) end. Brass cap No. 80 bench mark (BM) on the headwall on the landside (LS). [Additional Reference(s): DWR Levee Log, 2002. USACE San Joaquin O&M Manual 601.1, 1967, (HLM 8.41)]. FS Date: 4/9/2014

Concrete headwall, pipe, and flapgate at WS toe.

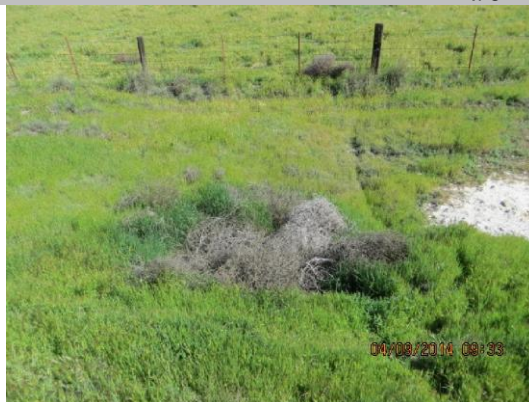
Photo 3 of 3 : UCIP_SP_2019_39245_60849.jpg

Pipe and concrete headwall at LS toe. Note heavy vegetation.

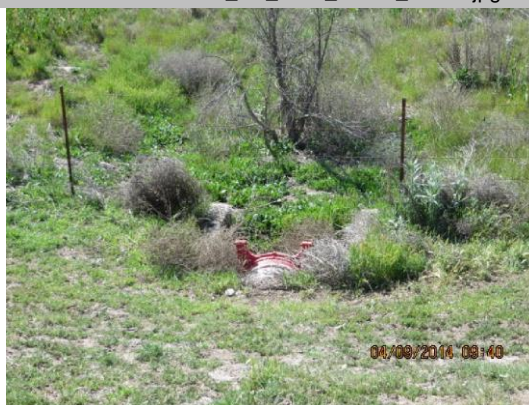
Photo 1 of 3 : UCIP_SP_2019_39246_60854.jpg

LM Start	8.57	Rating **	A/W	Issue No.	1220
LM End	8.57	Issue Type +	Ma	Location *	
Category	Supplemental			GPS Latitude/Longitude	
				Start	End
Item	DWR UCIP LMA Responsibility			37.296552 °	37.296552 °
				-120.858596 °	-120.858596 °
DWR ID	19622				
Comment Code					
Inspector Comment					
FS_ID:39246					
DS_ID:19622					
EP_NO: N/A					
Repair Type: No Action Needed					
Crossing Status: Found					
UCIP Comments:					
FIELD_STRUCT_DESC: 24-inch corrugated metal gravity drainage pipe through the levee, 9 feet below the crown. Flap gate on the waterside (WS) end. Brass cap No. 80 bench mark (BM) on the headwall on the landside (LS). [Additional Reference(s): DWR Levee Log, 2002. USACE San Joaquin O&M Manual 601.1, 1967, (HLM 8.61)].					
FS Date: 4/9/2014

Pipe, Flapgate, and headwall on WS toe.

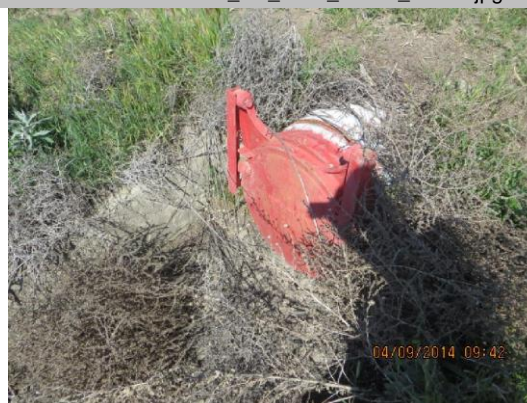
Photo 2 of 3 : UCIP_SP_2019_39246_60855.jpg

Pipe, Flapgate, and headwall on WS toe.

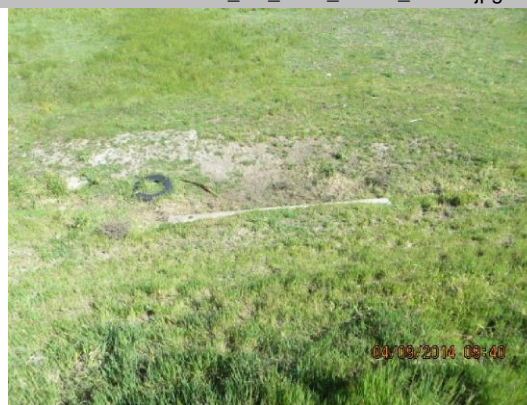
Photo 3 of 3 : UCIP_SP_2019_39246_60853.jpg

Pipe and headwall at LS toe.

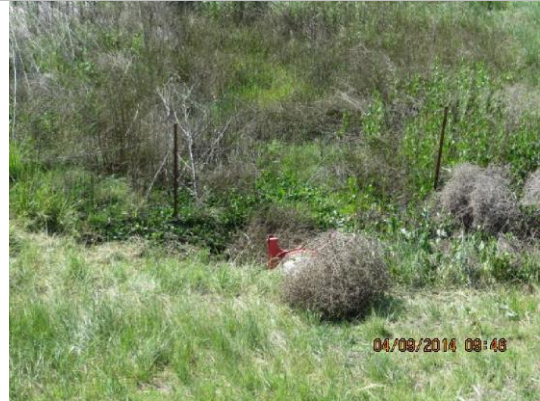
Photo 1 of 3 : UCIP_SP_2019_39247_60859.jpg

Comment Code						
Inspector Comment						
FS_ID:39247 DS_ID:19623 EP_NO: N/A Repair Type: Non-Urgent Crossing Status: Found UCIP Comments: 04/09/2014 Dense vegetation limits the inspector's visibility to identify signs of pipe failure (leaks) along the slope. Recommend removing vegetation along pipe alignment to conduct proper inspection of structure. (DWR UCIP - W. Wylie) FIELD_STRUCT_DESC: 24-inch corrugated metal gravity drainage pipe through the levee, 9.1 feet below the crown. Flap gate on the waterside (WS) end. Brass cap No. 80 bench mark (BM) on the headwall on the landside (LS). [Additional Reference(s): DWR Levee Log, 2002. USACE San Joaquin O&M Manual 601.1, 1967, (HLM 8.93)]. FS Date: 4/9/2014

Pipe, flapgate, and headwall on WS toe.

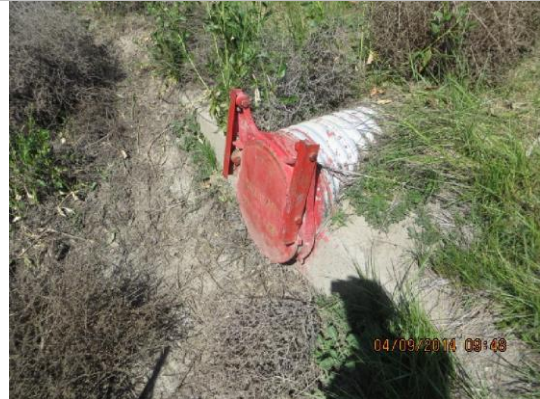
Photo 2 of 3 : UCIP_SP_2019_39247_60860.jpg

Pipe, flapgate, and headwall on WS toe.

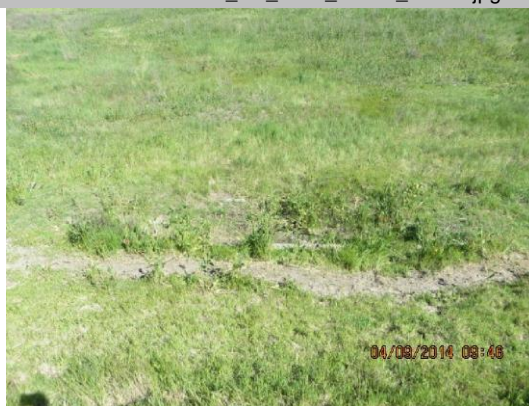
Photo 3 of 3 : UCIP_SP_2019_39247_60858.jpg

Comment Code						
Inspector Comment						
FS_ID:39247 DS_ID:19623 EP_NO: N/A Repair Type: Non-Urgent Crossing Status: Found UCIP Comments: 04/09/2014 Dense vegetation limits the inspector's visibility to identify signs of pipe failure (leaks) along the slope. Recommend removing vegetation along pipe alignment to conduct proper inspection of structure. (DWR UCIP - W. Wylie) FIELD_STRUCT_DESC: 24-inch corrugated metal gravity drainage pipe through the levee, 9.1 feet below the crown. Flap gate on the waterside (WS) end. Brass cap No. 80 bench mark (BM) on the headwall on the landside (LS). [Additional Reference(s): DWR Levee Log, 2002. USACE San Joaquin O&M Manual 601.1, 1967, (HLM 8.93)]. FS Date: 4/9/2014

Pipe and headwall visible on LS toe.

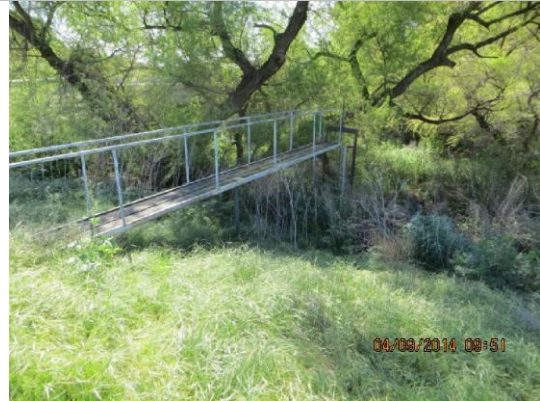
Photo 1 of 3 : UCIP_SP_2019_53190_60864.jpg

Comment Code						
Inspector Comment						
FS_ID:53190 DS_ID:19624 EP_NO: 12156 Repair Type: Urgent Crossing Status: Found UCIP Comments: 11/01/2018 Dense vegetation prevented a full inspection of this crossing. Assumed crossing remains the same as the 2016 inspection. Crossing remains Urgent due to signs of pipe being rusted through visible from the WS. Need to contact owner to clear the dense vegetation on both the WS and the LS to be able to perform proper inspection of crossing. (O. Magana - DWR UCIP)7/19/2016 same as previous inspection--pipe rusted through. Sediment visible inside LS pipe; walkway wood panels have dry rot and appears to be unsafe to use. (DWR UCIP - O. Magana)4/09/2014 Slide gate rusted through and open on WS toe. Inlet appears to be obscured or covered in soil at LS toe. Also dense vegetation on waterward and landward sides. Need to contact owner to contact CVFPB to address issue. (DWR UCIP - W. Wylie) FIELD_STRUCT_DESC: 26-inch steel pipe sleeved through a 30-inch reinforced concrete gravity drainage pipe through the levee, 7.3 feet below the crown. Annular space grouted between the two pipes. Two concrete cutoff walls in the center of the levee. Slide gate with elevated walkway access on the waterside (WS) end. 6-inch thick concrete headwall on the WS end. Concrete wing walls on each end. (Plans to install a 30-inch storm drainage pipe with a valve through the levee authorized under Permit No. 12156, 1977 - Merquin County Water District). (Additional Related Permit(s): Permit No. 12156-A, 1978 - Merquin County Water District). [Additional Reference(s): DWR Levee Log, 2002]. FS Date: 11/1/2018 12:50:00 PM

Metal walkway to slidegate operator on WS toe.

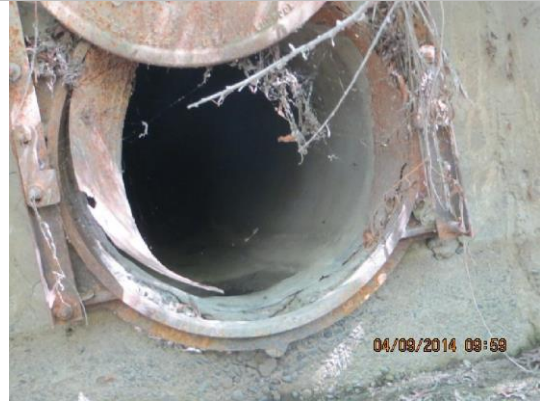
Photo 3 of 3 : UCIP_SP_2019_53190_60865.jpg

Comment Code						
Inspector Comment						
FS_ID:53190 DS_ID:19624 EP_NO: 12156 Repair Type: Urgent Crossing Status: Found UCIP Comments: 11/01/2018 Dense vegetation prevented a full inspection of this crossing. Assumed crossing remains the same as the 2016 inspection. Crossing remains Urgent due to signs of pipe being rusted through visible from the WS. Need to contact owner to clear the dense vegetation on both the WS and the LS to be able to perform proper inspection of crossing. (O. Magana - DWR UCIP)7/19/2016 same as previous inspection--pipe rusted through. Sediment visible inside LS pipe; walkway wood panels have dry rot and appears to be unsafe to use. (DWR UCIP - O. Magana)4/09/2014 Slide gate rusted through and open on WS toe. Inlet appears to be obscured or covered in soil at LS toe. Also dense vegetation on waterward and landward sides. Need to contact owner to contact CVFPB to address issue. (DWR UCIP - W. Wylie) FIELD_STRUCT_DESC: 26-inch steel pipe sleeved through a 30-inch reinforced concrete gravity drainage pipe through the levee, 7.3 feet below the crown. Annular space grouted between the two pipes. Two concrete cutoff walls in the center of the levee. Slide gate with elevated walkway access on the waterside (WS) end. 6-inch thick concrete headwall on the WS end. Concrete wing walls on each end. (Plans to install a 30-inch storm drainage pipe with a valve through the levee authorized under Permit No. 12156, 1977 - Merquin County Water District). (Additional Related Permit(s): Permit No. 12156-A, 1978 - Merquin County Water District). [Additional Reference(s): DWR Levee Log, 2002]. FS Date: 11/1/2018 12:50:00 PM

Slidegate rusted through and open on WS toe.

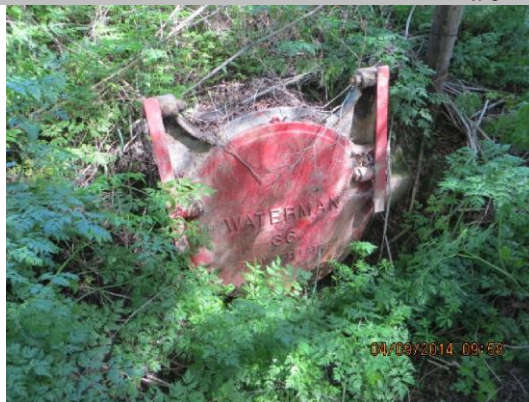
Photo 2 of 3 : UCIP_SP_2019_39249_60869.jpg

Pipe and flapgate visible on WS toe.

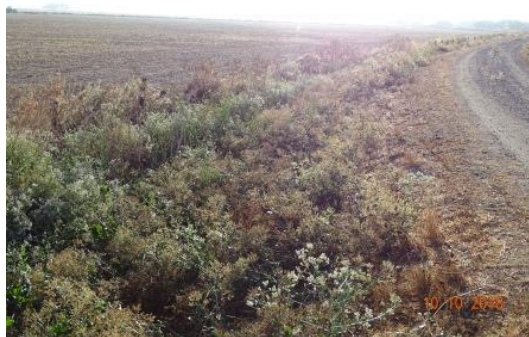
Photo 1 of 3 : SP_2019_NA0010_118_6_20190307_00004.jpg

LM Start	8.99	Rating **	U	Issue No.	6
LM End	9.61	Issue Type +	Ma	Location *	LS
Category	Earthen Levee			GPS Latitude/Longitude	
				Start	End
Item	Vegetation			37.297497 °	37.295138 °
				-120.851068 °	-120.840857 °
DWR ID	DWR_NA0010_01_s_2017_6				
Comment Code					
V2 : Remove the wild growth other than native grasses from the levee slopes.					
Inspector Comment					
Dense vegetation along landside slope.

Looking upstream at vegetation along landside slope. (Fall 2018)

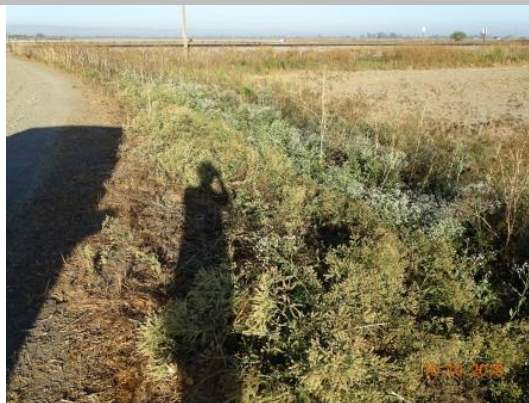
Photo 2 of 3 : SP_2019_NA0010_118_6_20190307_00005.jpg

LM Start	8.99	Rating **	U	Issue No.	6 (cont)	
LM End	9.61	Issue Type +	Ma	Location *	LS	
Category	Earthen Levee			GPS Latitude/Longitude		
				Start		End
Item	Vegetation			37.297497 °		37.295138 °
				-120.851068 °		-120.840857 °
DWR ID	DWR_NA0010_01_s_2017_6					
Comment Code						
V2 : Remove the wild growth other than native grasses from the levee slopes.						
Inspector Comment						
Dense vegetation along landside slope.

Looking downstream at vegetation along landside slope. (Fall 2018)

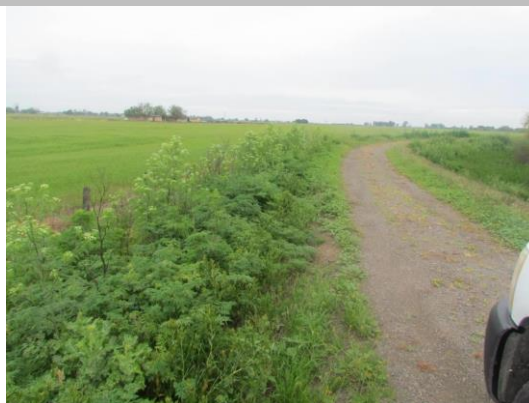
Photo 3 of 3 : SP_2019_NA0010_118_6_20190307_00006.jpg

Looking south at dense veg on landward slope.

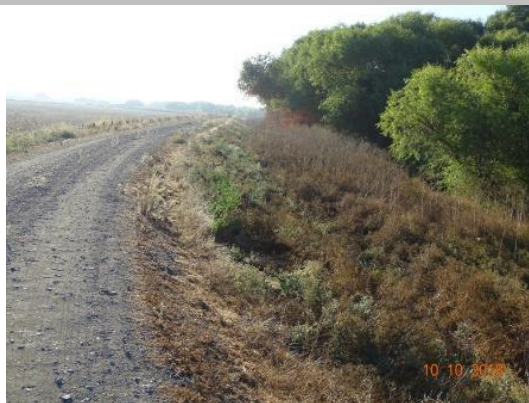
Photo 1 of 2 : SP_2019_NA0010_118_92_20190307_00015.jpg

LM Start	8.99	Rating **	U	Issue No.	92
LM End	9.66	Issue Type +	Ma	Location *	WS
Category	Earthen Levee			GPS Latitude/Longitude	
				Start	End
Item	Vegetation			37.297497 °	37.294588 °
				-120.851068 °	-120.840390 °
DWR ID	DWR_NA0010_01_s_2017_92				
Comment Code					
V2 : Remove the wild growth other than native grasses from the levee slopes.					
Inspector Comment					
Dense vegetation along waterside slope.

Looking upstream along waterside slope. (Fall 2018)

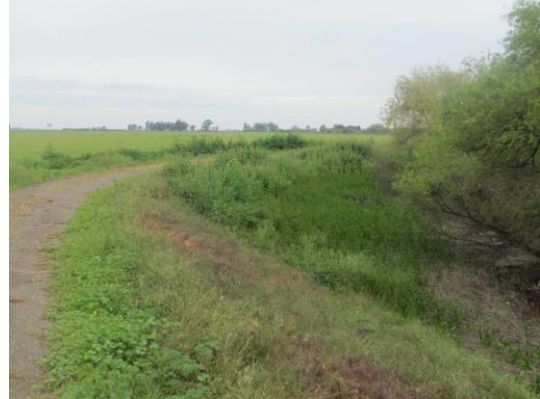
Photo 2 of 2 : SP_2019_NA0010_118_92_20190307_00016.jpg

LM Start	8.99	Rating **	U	Issue No.	92 (cont)	
LM End	9.66	Issue Type +	Ma	Location *	WS	
Category	Earthen Levee			GPS Latitude/Longitude		
				Start		End
Item	Vegetation			37.297497 °		37.294588 °
				-120.851068 °		-120.840390 °
DWR ID	DWR_NA0010_01_s_2017_92					
Comment Code						
V2 : Remove the wild growth other than native grasses from the levee slopes.						
Inspector Comment						
Dense vegetation along waterside slope.

Looking southwest at dense veg on waterward slope.

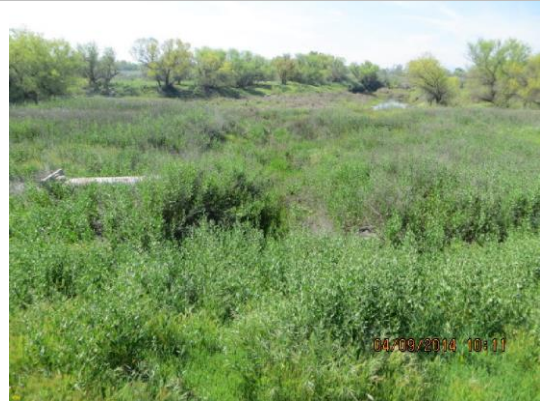
Photo 1 of 3 : UCIP_SP_2019_39251_60875.jpg

Comment Code						
Inspector Comment						
FS_ID:39251						
DS_ID:19627						
EP_NO: N/A						
Repair Type: Non-Urgent						
Crossing Status: Found						
UCIP Comments: 04/09/2014 Dense vegetation limits the inspector's visibility to identify signs of pipe failure (leaks) along the slope.						
Recommend removing vegetation along pipe alignment to conduct proper inspection of structure. (DWR UCIP - W. Wylie)						
FIELD_STRUCT_DESC: 24-inch corrugated metal gravity drainage pipe through the levee, 8.6 feet below the crown. Concrete drop inlet at the landside (LS) toe. Flap gate on the waterside (WS) end. Brass cap No. 80 bench mark (BM) on the headwall on the LS. [Additional Reference(s): DWR Levee Log, 2002. USACE San Joaquin O&M Manual 601.1, 1967, (HLM 9.37)].						
FS Date: 4/9/2014

Pipe and flapgate on WS toe.

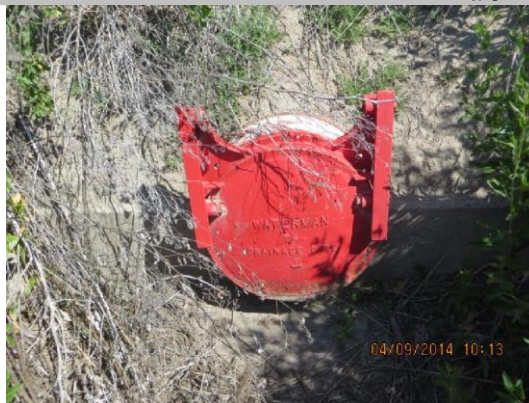
Photo 2 of 3 : UCIP_SP_2019_39251_60876.jpg

Comment Code						
Inspector Comment						
FS_ID:39251						
DS_ID:19627						
EP_NO: N/A						
Repair Type: Non-Urgent						
Crossing Status: Found						
UCIP Comments: 04/09/2014 Dense vegetation limits the inspector's visibility to identify signs of pipe failure (leaks) along the slope. Recommend removing vegetation along pipe alignment to conduct proper inspection of structure. (DWR UCIP - W. Wylie)						
FIELD_STRUCT_DESC: 24-inch corrugated metal gravity drainage pipe through the levee, 8.6 feet below the crown. Concrete drop inlet at the landside (LS) toe. Flap gate on the waterside (WS) end. Brass cap No. 80 bench mark (BM) on the headwall on the LS. [Additional Reference(s): DWR Levee Log, 2002. USACE San Joaquin O&M Manual 601.1, 1967, (HLM 9.37)].						
FS Date: 4/9/2014

Headwall, Pipe, and flapgate on WS toe.

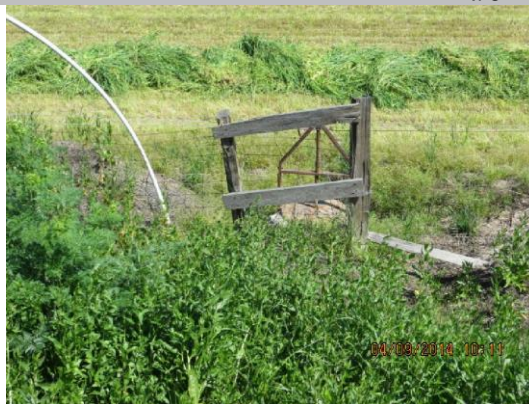
Photo 3 of 3 : UCIP_SP_2019_39251_60874.jpg

Concrete drop-inlet installed on pipe at LS toe.

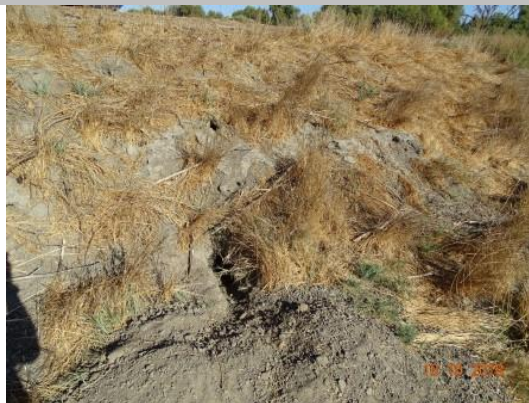
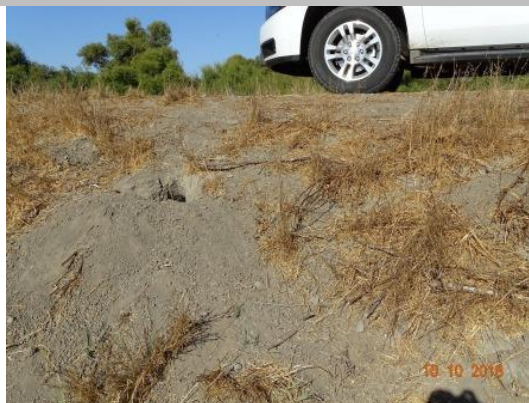
LM Start	9.94	Rating **	U	Issue No.	120
LM End	9.97	Issue Type +	Ma	Location *	LS
Category	Earthen Levee			GPS Latitude/Longitude	
				Start	End
Item	Animal Control			37.290994 °	37.290673 °
				-120.839758 °	-120.839988 °
DWR ID	DWR_NA0010_01_f_2018_120				
Comment Code					
A3 : No rodents visible, but rodent burrows visible; need to backfill and compact or grout burrows.					
Inspector Comment					
Rodent burrows observed in this section with large amount of material displaced.

Representative view of rodent burrow. (Fall 2018)

View of another rodent burrow. (Fall 2018)

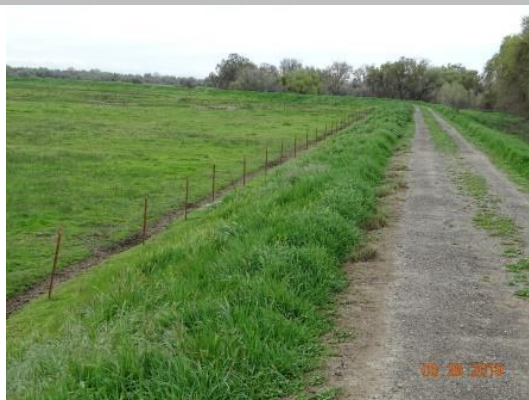
Photo 1 of 1 : SP_2019_NA0010_118_111_20190402_00287.jpg

LM Start	9.94	Rating **	M	Issue No.	111
LM End	10.67	Issue Type +	Ma	Location *	LS
Category	Earthen Levee			GPS Latitude/Longitude	
				Start	End
Item	Vegetation			37.290991 °	37.283752 °
				-120.839754 °	-120.833588 °
DWR ID	DWR_NA0010_01_s_2019_111				
Comment Code					
V1 : Control annual grass and weeds on the levee slopes and easements.					
Inspector Comment

View of vegetation along landside slope looking upstream. (Spring 2019)

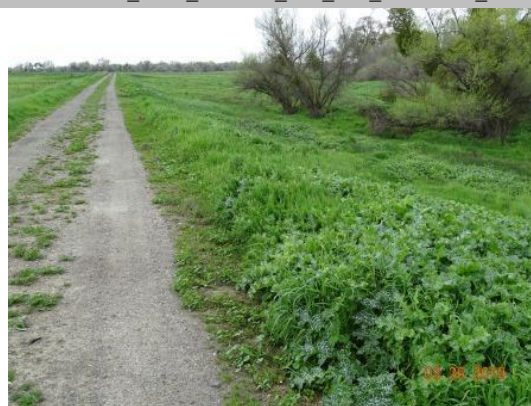
Photo 1 of 1 : SP_2019_NA0010_118_131_20190402_00292.jpg

LM Start	9.97	Rating **	U	Issue No.	131
LM End	10.53	Issue Type +	Ma	Location *	WS
Category	Earthen Levee			GPS Latitude/Longitude	
				Start	End
Item	Vegetation			37.290563 °	37.284409 °
				-120.840067 °	-120.836056 °
DWR ID	DWR_NA0010_01_s_2019_131				
Comment Code					
V1 : Control annual grass and weeds on the levee slopes and easements.					
Inspector Comment

View of waterside slope looking upstream. (Spring 2019)

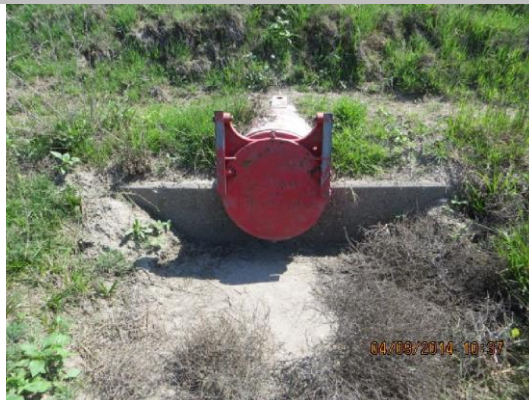
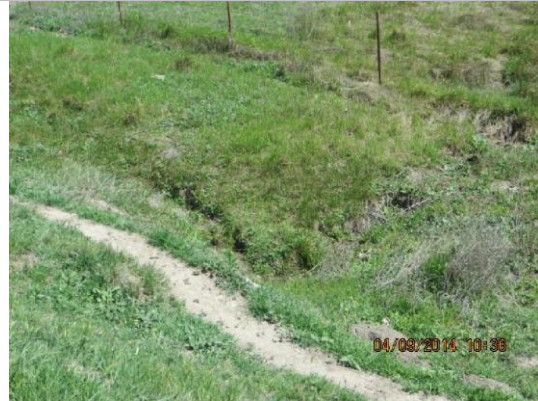
Comment Code					
Inspector Comment					
FS_ID:39253 DS_ID:19629 EP_NO: N/A Repair Type: Non-Urgent Crossing Status: Found UCIP Comments: 04/09/2014 Dense vegetation blocks waterward and landward toes Recommend removing vegetation from both toes. Also sediment buildup in pipe visible from landward side. (DWR UCIP - W. Wylie) FIELD_STRUCT_DESC: 24-inch corrugated metal gravity drainage pipe through the levee, 9 feet below the crown. Flap gate on the waterside (WS) end. Brass cap No. 69 bench mark (BM) on the headwall on the landside (LS). [Additional Reference(s): DWR Levee Log, 2002. USACE San Joaquin O&M Manual 601.1, 1967, (HLM 10.23)]. FS Date: 4/9/2014

Pipe, headwall, and flapgate on WS toe.

Pipe, headwall, and flapgate at WS toe.

Item	DWR UCIP LMA Responsibility			37.287511 °	37.287511 °	
				-120.840251 °	-120.840251 °	
DWR ID	19629					
Comment Code						
Inspector Comment						
FS_ID:39253 DS_ID:19629 EP_NO: N/A Repair Type: Non-Urgent Crossing Status: Found UCIP Comments: 04/09/2014 Dense vegetation blocks waterward and landward toes Recommend removing vegetation from both toes. Also sediment buildup in pipe visible from landward side. (DWR UCIP - W. Wylie) FIELD_STRUCT_DESC: 24-inch corrugated metal gravity drainage pipe through the levee, 9 feet below the crown. Flap gate on the waterside (WS) end. Brass cap No. 69 bench mark (BM) on the headwall on the landside (LS). [Additional Reference(s): DWR Levee Log, 2002. USACE San Joaquin O&M Manual 601.1, 1967, (HLM 10.23)]. FS Date: 4/9/2014

Pipe and headwall at LS toe.

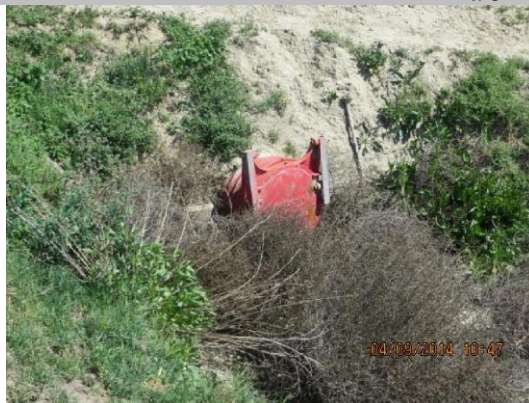
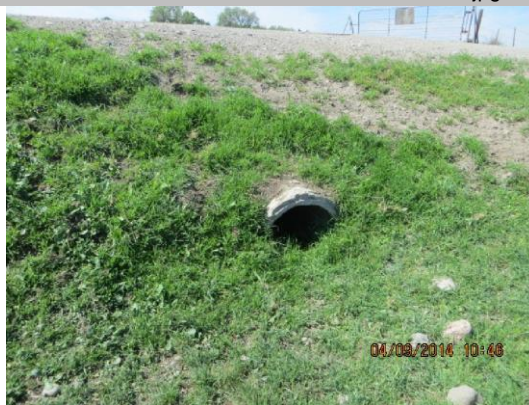
LM Start	10.69	Rating **	A/W	Issue No.	1229 (cont)	
LM End	10.69	Issue Type +	Ma	Location *		
Category	Supplemental			GPS Latitude/Longitude		
				Start	End	
Item	DWR UCIP LMA Responsibility			37.283710 °	37.283710 °	
				-120.833329 °	-120.833329 °	
DWR ID	19631					
Comment Code						
Inspector Comment						
FS_ID:39254						
DS_ID:19631						
EP_NO: N/A						
Repair Type: No Action Needed						
Crossing Status: Found						
UCIP Comments:						
FIELD_STRUCT_DESC: 24-inch corrugated metal gravity drainage pipe						
through the levee, 7 feet below the crown. Flap gate on the waterside						
(WS) end. Brass cap No. 67 bench mark (BM) on the headwall on the						
landside (LS). [Additional Reference(s): DWR Levee Log, 2002. USACE						
San Joaquin O&M Manual 601.1, 1967, (HLM 10.72)].						
FS Date: 4/9/2014

Headwall, pipe, and flapgate on WS toe.

Concrete pipe visible on LS slope.

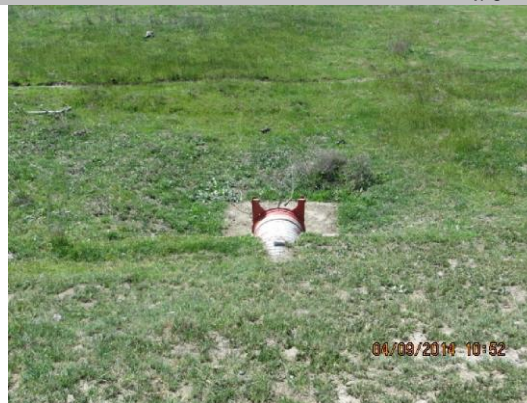
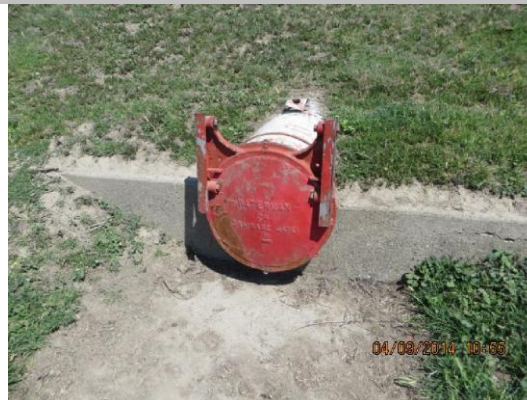
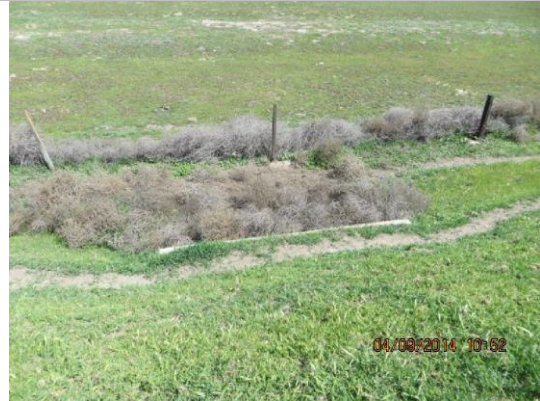
Pipe, headwall, and flapgate on WS toe.

Item	DWR UCIP LMA Responsibility			37.282627 °	37.282627 °	
				-120.828233 °	-120.828233 °	
DWR ID	19632					
Comment Code						
Inspector Comment						
FS_ID:39255						
DS_ID:19632						
EP_NO: N/A						
Repair Type: Non-Urgent						
Crossing Status: Found						
UCIP Comments: 04/09/2014 Dense vegetation blocks landward headwall. Recommend removing excess vegetation on landward toe. (DWR UCIP - W. Wylie)						
FIELD_STRUCT_DESC: 24-inch corrugated metal gravity drainage pipe through the levee, 6 feet below the crown. Flap gate on the waterside (WS) end. Brass cap No. 66 bench mark (BM) on the headwall on the landside (LS). [Additional Reference(s): DWR Levee Log, 2002. USACE San Joaquin O&M Manual 601.1, 1967, (HLM 11.00)].						
FS Date: 4/9/2014

Pipe and headwall on LS toe.

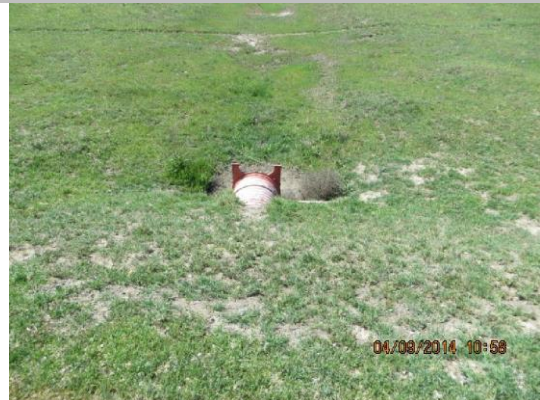
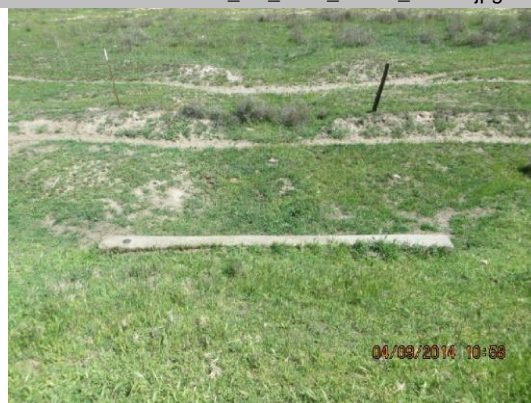
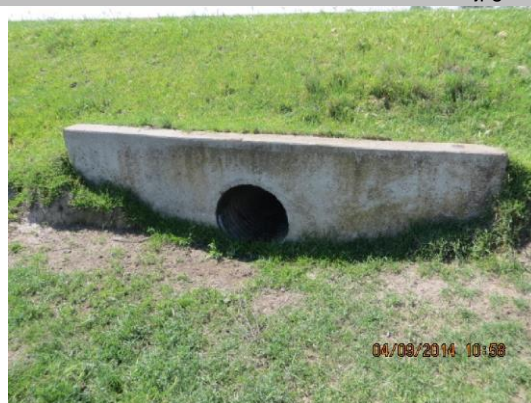
Pipe, headwall, and flapgate on WS toe.

LM Start	11.14	Rating **	A/W	Issue No.	1231 (cont)
LM End	11.14	Issue Type +	Ma	Location *	
Category	Supplemental			GPS Latitude/Longitude	
				Start	End
Item	DWR UCIP LMA Responsibility			37.281813 °	37.281813 °
				-120.825409 °	-120.825409 °
DWR ID	19633				
Comment Code					
Inspector Comment					
FS_ID:33690					
DS_ID:19633					
EP_NO: N/A					
Repair Type: No Action Needed					
Crossing Status: Found					
UCIP Comments:					
FIELD_STRUCT_DESC: 24-inch corrugated metal gravity drainage pipe					
through the levee, 5 feet below the crown. Flap gate on the waterside					
(WS) end. Brass cap No. 65 bench mark (BM) on the headwall on the					
landside (LS). [Additional Reference(s): DWR Levee Log, 2002. USACE					
San Joaquin O&M Manual 601.1, 1967, (HLM 11.18)].					
FS Date: 4/9/2014

Pipe and headwall at LS toe.

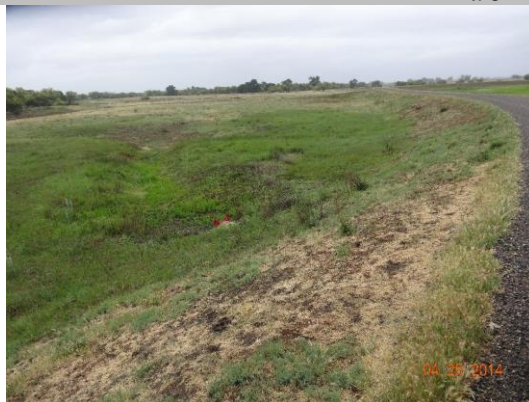
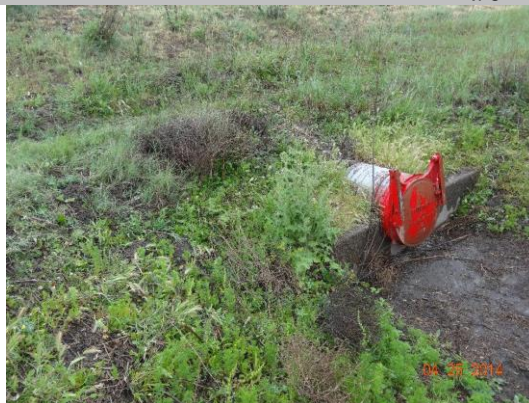
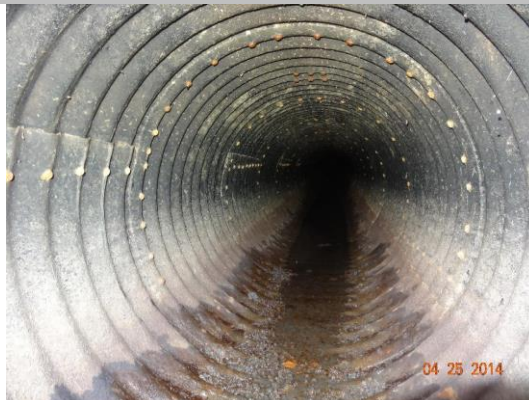
Comment Code					
Inspector Comment					
FS_ID:36103 DS_ID:19634 EP_NO: N/A Repair Type: Non-Urgent Crossing Status: Found UCIP Comments: 04/25/2014 Need to contact owner--landward side has been buried. It appears that soil was removed from levee toe, immediately upstream, and used to pile soil at landward side at crossing. (DWR UCIP - O. Magana) FIELD_STRUCT_DESC: 24-inch corrugated metal gravity drainage pipe through the levee, 10 feet below the crown. Flap gate on the waterside (WS) end. Brass cap No. 62 bench mark (BM) on the headwall on the landside (LS). [Additional Reference(s): DWR Levee Log, 2002. USACE San Joaquin O&M Manual 601.1, 1967, (HLM 11.48)]. FS Date: 4/25/2014

View of waterward side.

View of concrete headwall and flap gate visible on waterward side.

Inside view of pipe from waterward side.

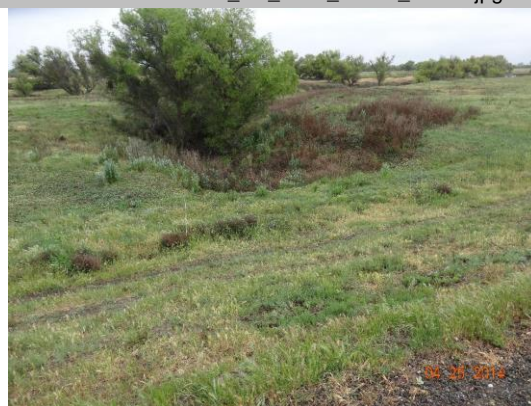
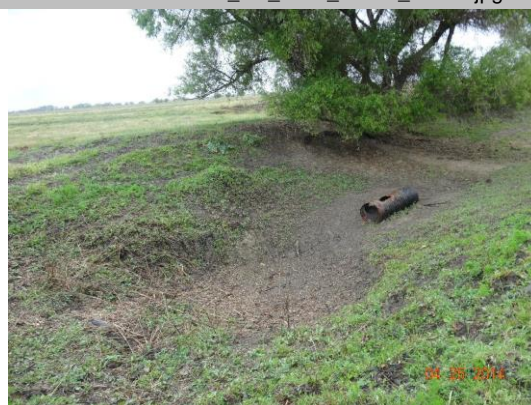
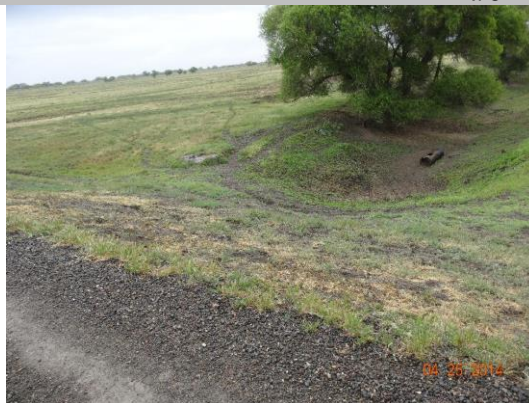
Comment Code					
Inspector Comment					
FS_ID:36105 DS_ID:19635 EP_NO: N/A Repair Type: Non-Urgent Crossing Status: Found UCIP Comments: 04/25/2014 Crossing is non-functional --landward side is buried. Debris found on landward side (channel). Dense vegetation found on waterward slope. Recommend contacting owner to determine status of crossing. If crossing is no longer used need to coordinate with CVFPB for proper abandonment. (DWR UCIP - O. Magana) FIELD_STRUCT_DESC: 24-inch corrugated metal gravity drainage pipe through the levee, 17 feet below the crown. Flap gate on the waterside (WS) end. Brass cap No. 61 bench mark (BM) on the headwall on the landside (LS). [Additional Reference(s): DWR Levee Log, 2002. USACE San Joaquin O&M Manual 601.1, 1967, (HLM 11.76)]. FS Date: 4/25/2014

View of waterward side.

Landward side of crossing buried--damage pipe section visible on landward side.

View of landward side.

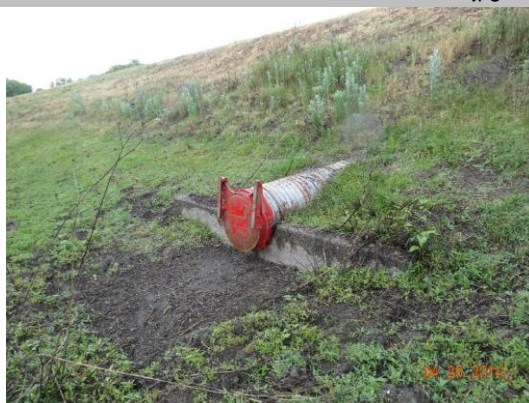
Photo 2 of 3 : UCIP_SP_2019_36106_65379.jpg

Flap gate and concrete headwall visible on waterward side.

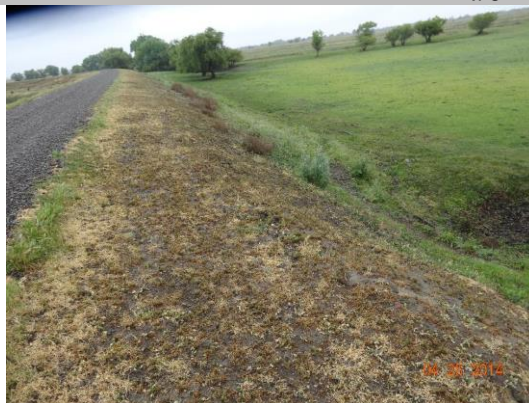
Photo 3 of 3 : UCIP_SP_2019_36106_65377.jpg

Item	DWR UCIP LMA Responsibility			37.265336 °		37.265336 °
				-120.826591 °		-120.826591 °
DWR ID	19636					
Comment Code						
Inspector Comment						
FS_ID:36106 DS_ID:19636 EP_NO: N/A Repair Type: Non-Urgent Crossing Status: Found UCIP Comments: 04/25/2014 Crossing is non-functional --landward side is buried. Dense vegetation found on waterward slope. Recommend contacting owner to determine status of crossing. If crossing is no longer used need to coordinate with CVFPB for proper abandonment. (DWR UCIP - O. Magana) FIELD_STRUCT_DESC: 24-inch corrugated metal gravity drainage pipe through the levee, 12.4 feet below the crown. Flap gate on the waterside (WS) end. Brass cap No. 60 bench mark (BM) on the headwall on the landside (LS). [Additional Reference(s): DWR Levee Log, 2002. USACE San Joaquin O&M Manual 601.1, 1967, (HLM 12.11)]. FS Date: 4/25/2014

View of landward side.

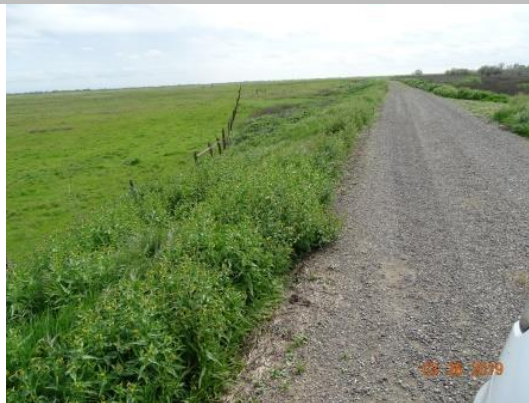
Photo 1 of 1 : SP_2019_NA0010_118_127_20190402_00288.jpg

LM Start	12.62	Rating **	U	Issue No.	127
LM End	17.44	Issue Type +	Ma	Location *	LS
Category	Earthen Levee			GPS Latitude/Longitude	
				Start	End
Item	Vegetation			37.258951 °	37.216002 °
				-120.826387 °	-120.779165 °
DWR ID	DWR_NA0010_01_f_2018_127				
Comment Code					
V1 : Control annual grass and weeds on the levee slopes and easements.					
Inspector Comment

View of landside slope looking upstream. (Spring 2019)

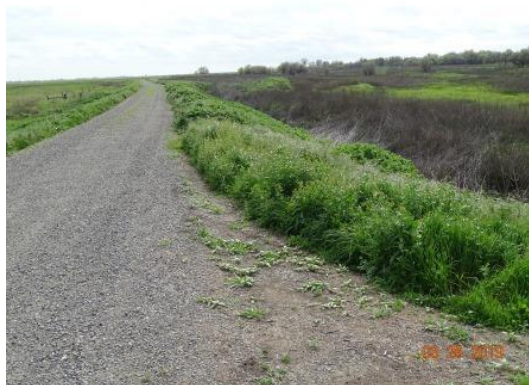
Photo 1 of 1 : SP_2019_NA0010_118_133_20190402_00289.jpg

LM Start	12.62	Rating **	U	Issue No.	133
LM End	17.44	Issue Type +	Ma	Location *	WS
Category	Earthen Levee			GPS Latitude/Longitude	
				Start	End
Item	Vegetation			37.258950 °	37.216003 °
				-120.826387 °	-120.779165 °
DWR ID	DWR_NA0010_01_s_2019_133				
Comment Code					
V1 : Control annual grass and weeds on the levee slopes and easements.					
Inspector Comment

View of waterside slope looking upstream. (Spring 2019)

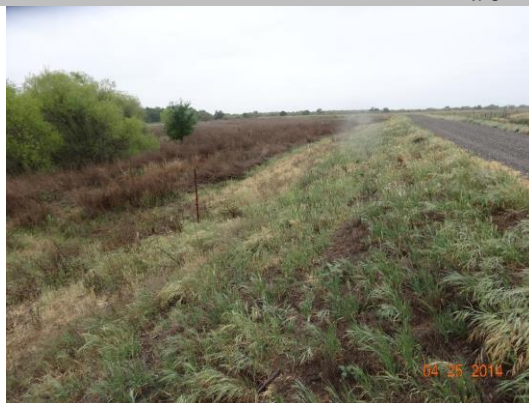
Photo 1 of 3 : UCIP_SP_2019_36146_65412.jpg

Comment Code					
Inspector Comment					
FS_ID:36146					
DS_ID:19637					
EP_NO: N/A					
Repair Type: Non-Urgent					
Crossing Status: Found					
UCIP Comments: 04/25/2014 Concrete headwall on landward side blocked by debris. Dense vegetation limits the inspector's visibility to identify signs of pipe failure (leaks) along the landward slope. Recommend removing vegetation along pipe alignment to conduct proper inspection of crossing. (DWR UCIP - O. Magana)					
FIELD_STRUCT_DESC: 24-inch corrugated metal gravity drainage pipe through the levee, 9.5 feet below the crown. Flap gate on the waterside (WS) end. Brass cap No. 60 bench mark (BM) on the headwall on the landside (LS). [Additional Reference(s): DWR Levee Log, 2002. USACE San Joaquin O&M Manual 601.1, 1967, (HLM 12.94)].					
FS Date: 4/25/2014

View of waterward side.

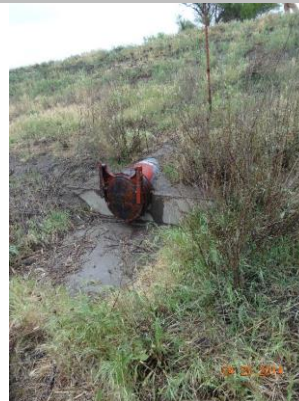
Photo 2 of 3 : UCIP_SP_2019_36146_65411.jpg

Flap gate and concrete headwall visible on waterward side.

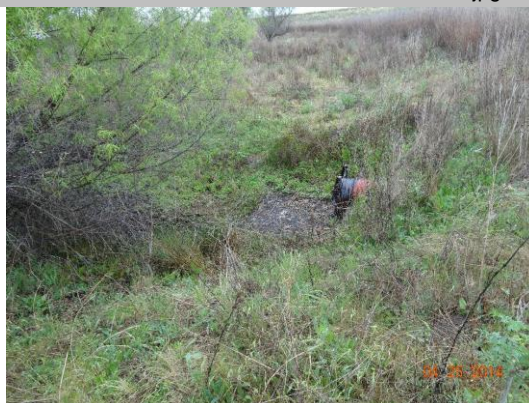
Photo 2 of 3 : UCIP_SP_2019_36109_65387.jpg

View of flap gate and pipe through levee on waterward side.

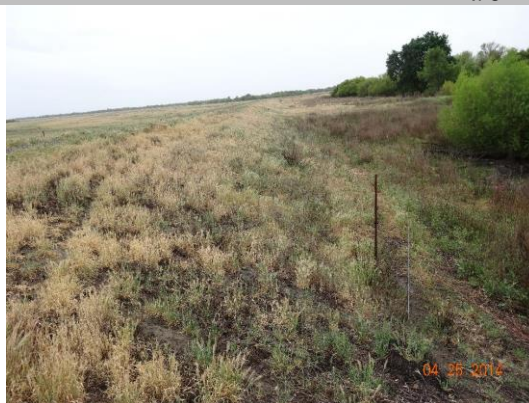
Photo 1 of 3 : UCIP_SP_2019_39256_65418.jpg

Comment Code						
Inspector Comment						
FS_ID:39256 DS_ID:19639 EP_NO: N/A Repair Type: Non-Urgent Crossing Status: Found UCIP Comments: 04/25/2014 No access to waterward toe due to fence. Unable to find the concrete headwall and flap gate on waterward side past fence. Also dense vegetation limits the inspector's visibility to identify signs of pipe failure (leaks) along the waterward slope. Recommend removing vegetation along pipe alignment to conduct proper inspection of structure. Also need access past fence on waterward side. (DWR UCIP - O. Magana) FIELD_STRUCT_DESC: 24-inch corrugated metal gravity drainage pipe through the levee, 14.5 feet below the crown. Flap gate on the waterside (WS) end. Brass cap No. 60 bench mark (BM) on the headwall on the landside (LS). [Additional Reference(s): DWR Levee Log, 2002. USACE San Joaquin O&M Manual 601.1, 1967, (HLM 13.58)]. FS Date: 4/25/2014

View of waterward side.

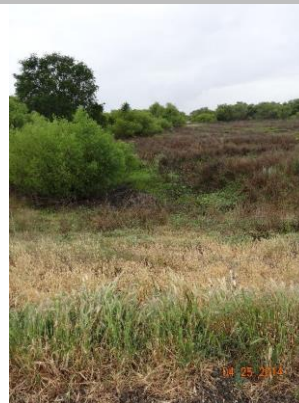
Photo 2 of 3 : UCIP_SP_2019_39256_65417.jpg

Dense vegetation on waterward side.

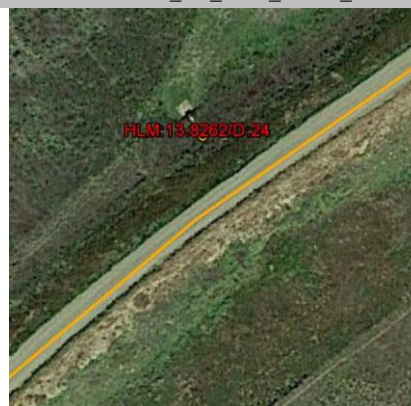
Photo 1 of 1 : UCIP_SP_2019_36544_66286.jpg

Comment Code						
Inspector Comment						
FS_ID:36544 DS_ID:19640 EP_NO: N/A Repair Type: Non-Urgent Crossing Status: Indicator Found UCIP Comments: 04/25/2014 No photos available--missed crossing. Aerial photograph indicates crossing is present. Need to confirm if crossing is still present on waterward side. (DWR UCIP - O. Magana) FIELD_STRUCT_DESC: 24-inch corrugated metal gravity drainage pipe through the levee, 11 feet below the crown. Flap gate on the waterside (WS) end. Brass cap No. 60 bench mark (BM) on the headwall on the landside (LS). [Additional Reference(s): DWR Levee Log, 2002. USACE San Joaquin O&M Manual 601.1, 1967, (HLM 13.81)]. FS Date: 4/25/2014

Indicators of crossing visible from aerial photograph.

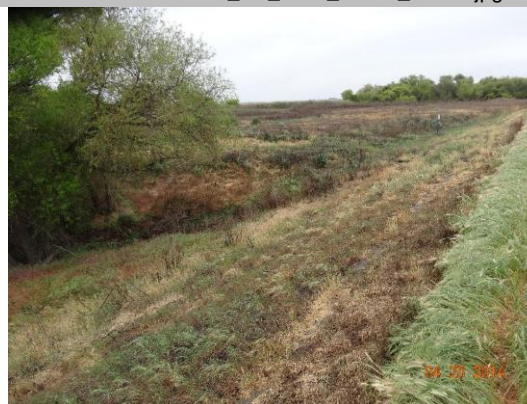
Photo 1 of 3 : UCIP_SP_2019_36166_65449.jpg

Comment Code					
Inspector Comment					
FS_ID:36166					
DS_ID:19641					
EP_NO: N/A					
Repair Type: Non-Urgent					
Crossing Status: Found					
UCIP Comments: 04/25/2014 Dense vegetation limits the inspector's visibility to identify signs of pipe failure (leaks) along the slopes. Recommend removing vegetation along pipe alignment to conduct proper inspection of structure. (DWR UCIP - O. Magana)					
FIELD_STRUCT_DESC: 24-inch corrugated metal gravity drainage pipe through the levee, 13 feet below the crown. Flap gate on the waterside (WS) end. Brass cap No. 60 bench mark (BM) on the headwall on the landside (LS). [Additional Reference(s): DWR Levee Log, 2002. USACE San Joaquin O&M Manual 601.1, 1967, (HLM 14.21)].					
FS Date: 4/25/2014

View of waterward side.

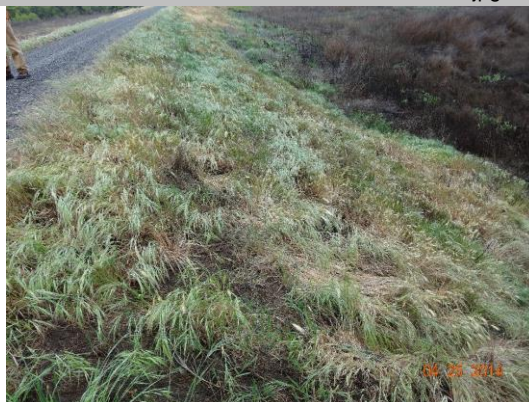
Photo 3 of 3 : UCIP_SP_2019_36166_65448.jpg

Item	DWR UCIP LMA Responsibility			37.242225 °	37.242225 °	
				-120.817665 °	-120.817665 °	
DWR ID	19641					
Comment Code						
Inspector Comment						
FS_ID:36166						
DS_ID:19641						
EP_NO: N/A						
Repair Type: Non-Urgent						
Crossing Status: Found						
UCIP Comments: 04/25/2014 Dense vegetation limits the inspector's visibility to identify signs of pipe failure (leaks) along the slopes. Recommend removing vegetation along pipe alignment to conduct proper inspection of structure. (DWR UCIP - O. Magana)						
FIELD_STRUCT_DESC: 24-inch corrugated metal gravity drainage pipe through the levee, 13 feet below the crown. Flap gate on the waterside (WS) end. Brass cap No. 60 bench mark (BM) on the headwall on the landside (LS). [Additional Reference(s): DWR Levee Log, 2002. USACE San Joaquin O&M Manual 601.1, 1967, (HLM 14.21)].						
FS Date: 4/25/2014

View of landward side.

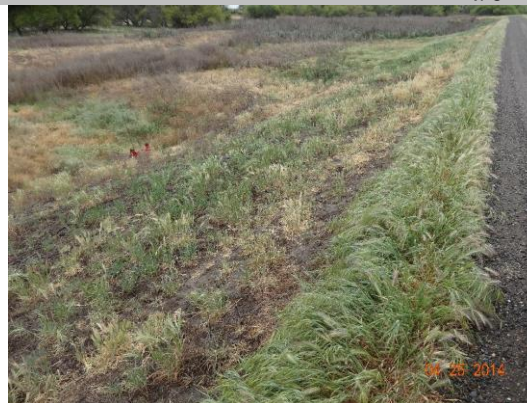
Photo 1 of 3 : UCIP_SP_2019_36167_65455.jpg

Comment Code					
Inspector Comment					
FS_ID:36167 DS_ID:19642 EP_NO: N/A Repair Type: Non-Urgent Crossing Status: Found UCIP Comments: 04/25/2014 Dense vegetation limits the inspector's visibility to identify signs of pipe failure (leaks) along the landward slope and toe. Recommend removing vegetation along pipe alignment to conduct proper inspection of structure. (DWR UCIP - O. Magana) FIELD_STRUCT_DESC: 24-inch corrugated metal gravity drainage pipe through the levee, 9.7 feet below the crown. Flap gate on the waterside (WS) end. Brass cap No. 60 bench mark (BM) on the headwall on the landside (LS). [Additional Reference(s): DWR Levee Log, 2002. USACE San Joaquin O&M Manual 601.1, 1967, (HLM 14.65)]. FS Date: 4/25/2014

View of waterward side.

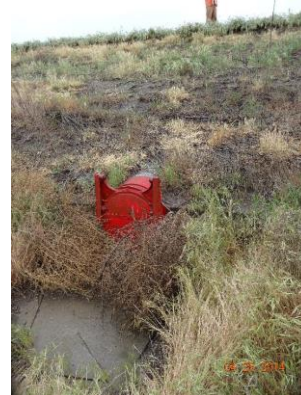
Photo 2 of 3 : UCIP_SP_2019_36167_65454.jpg

Flap gate, concrete headwall, and concrete apron located on waterward toe.
