**Flood Control Project Maintenance
Levee Inspections**
LMA District Cover Sheet
Spring 2019 Levee Inspection Results

Lower San Joaquin Levee District

Spring 2019 Levee Inspection Results

Waterway			Bank	Unit Miles
Unit No. 01 San Joaquin River			Right	22.52
	Spring (March - May)	Summer (June - August)	(September - November) Fall	Winter (December - February)
Unit Maintenance Rating (Fall Only)				
Date of Inspection	3/26/2019 - 3/26/2019			
DWR Inspector	Corey Fujitani			
Accompanied By

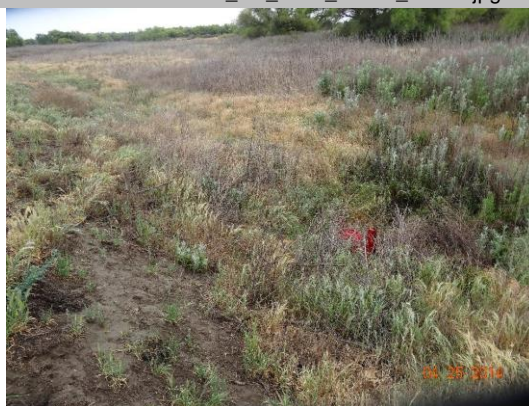
Photo 1 of 3 : UCIP_SP_2019_36169_65464.jpg

Comment Code					
Inspector Comment					
FS_ID:36169 DS_ID:19644 EP_NO: N/A Repair Type: Non-Urgent Crossing Status: Found UCIP Comments: 04/25/2014 Dense vegetation limits the inspector's visibility to identify signs of pipe failure (leaks) along the waterward and landward slopes. Recommend removing vegetation along pipe alignment to conduct proper inspection of structure. (DWR UCIP - O. Magana) FIELD_STRUCT_DESC: 24-inch corrugated metal gravity drainage pipe through the levee, 8.5 feet below the crown. Flap gate on the waterside (WS) end. Brass cap No. 60 bench mark (BM) on the headwall on the landside (LS). [Additional Reference(s): DWR Levee Log, 2002. USACE San Joaquin O&M Manual 601.1, 1967, (HLM 15.57)]. FS Date: 4/25/2014

View of waterward side--flap gate visible through dense vegetation.

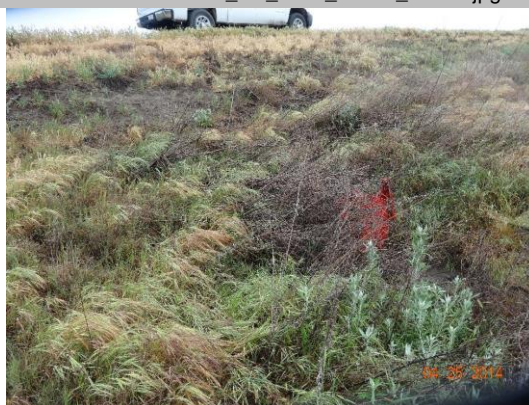
Photo 2 of 3 : UCIP_SP_2019_36169_65463.jpg

View of waterward slope covered by dense vegetation.

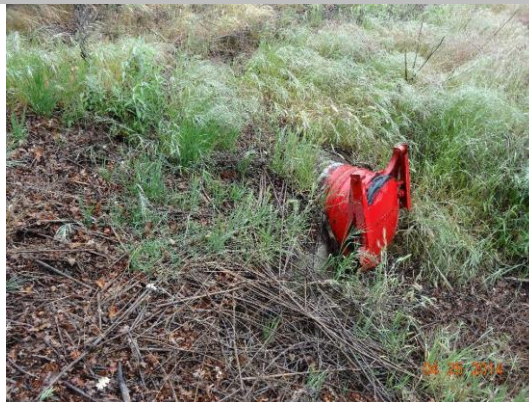
Photo 3 of 3 : UCIP_SP_2019_36171_65469.jpg

Comment Code					
Inspector Comment					
FS_ID:36171 DS_ID:19645 EP_NO: N/A Repair Type: Non-Urgent Crossing Status: Found UCIP Comments: 04/25/2014 Dense vegetation limits the inspector's visibility to identify signs of pipe failure (leaks) along the waterward and landward slope. Recommend removing vegetation along pipe alignment to conduct proper inspection of structure. (DWR UCIP - O. Magana) FIELD_STRUCT_DESC: 24-inch corrugated metal gravity drainage pipe through the levee, 11 feet below the crown. Flap gate on the waterside (WS) end. Brass cap No. 60 bench mark (BM) on the headwall on the landside (LS). [Additional Reference(s): DWR Levee Log, 2002. USACE San Joaquin O&M Manual 601.1, 1967, (HLM 15.81)]. FS Date: 4/25/2014

Side view of pipe and flap gate on waterward side.

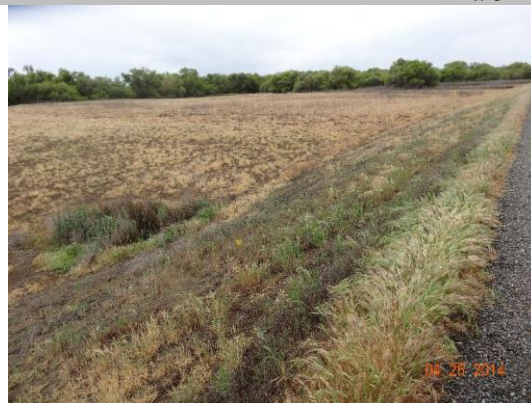
Photo 1 of 3 : UCIP_SP_2019_36172_65476.jpg

Comment Code					
Inspector Comment					
FS_ID:36172 DS_ID:19646 EP_NO: N/A Repair Type: Non-Urgent Crossing Status: Found UCIP Comments: 04/25/2014 Dense vegetation limits the inspector's visibility to identify signs of pipe failure (leaks) along the waterward and landward slopes. Recommend removing vegetation along pipe alignment to conduct proper inspection of structure and appurtenances. (DWR UCIP - O. Magana) FIELD_STRUCT_DESC: 24-inch corrugated metal gravity drainage pipe through the levee, 11.3 feet below the crown. Flap gate on the waterside (WS) end. Brass cap No. 50 bench mark (BM) on the headwall on the landside (LS). [Additional Reference(s): DWR Levee Log, 2002. USACE San Joaquin O&M Manual 601.1, 1967, (HLM 16.09)]. FS Date: 4/25/2014

View of waterward side.

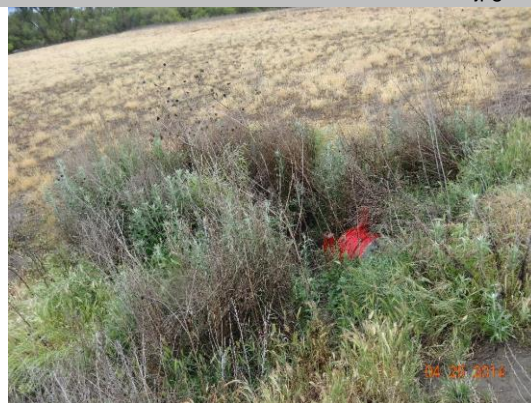
Photo 2 of 3 : UCIP_SP_2019_36172_65475.jpg

Flap gate visible on waterward toe.

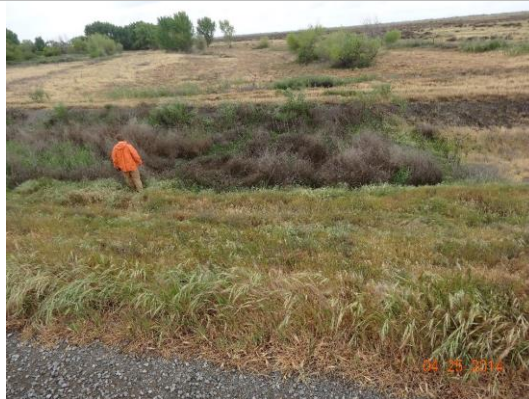
Photo 3 of 3 : UCIP_SP_2019_39257_65478.jpg

Item	DWR UCIP LMA Responsibility			37.224120 °		37.224120 °
				-120.794002 °		-120.794002 °
DWR ID	19647					
Comment Code						
Inspector Comment						
FS_ID:39257 DS_ID:19647 EP_NO: N/A Repair Type: Non-Urgent Crossing Status: Found UCIP Comments: 04/25/2014 Dense vegetation limits the inspector's visibility to identify signs of pipe failure (leaks) along the waterward and landward slopes. Recommend removing vegetation along pipe alignment to conduct proper inspection of structure. Unable to find pipe on landward side. (DWR UCIP - O. Magana) FIELD_STRUCT_DESC: 24-inch corrugated metal gravity drainage pipe through the levee, 14.7 feet below the crown. Flap gate on the waterside (WS) end. Brass cap No. 50 bench mark (BM) on the headwall on the landside (LS). [Additional Reference(s): DWR Levee Log, 2002. USACE San Joaquin O&M Manual 601.1, 1967, (HLM 16.15)]. FS Date: 4/25/2014

View of landward side.

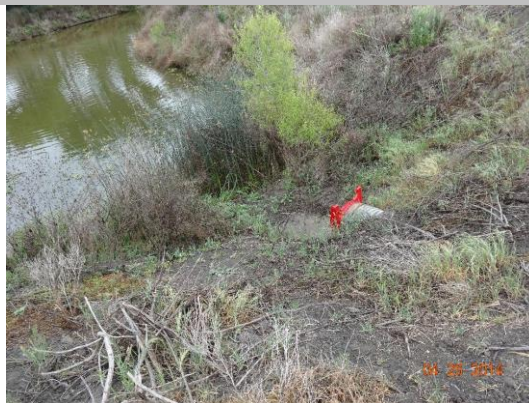
Photo 2 of 3 : UCIP_SP_2019_39258_66289.jpg

Comment Code					
Inspector Comment					
FS_ID:39258 DS_ID:19648 EP_NO: N/A Repair Type: Non-Urgent Crossing Status: Found UCIP Comments: 04/25/2014 Dense vegetation limits the inspector's visibility to identify signs of pipe failure (leaks) along the waterward and landward slopes. Recommend removing vegetation along pipe alignment to conduct proper inspection of structure. Unable to find pipe on landward side. (DWR UCIP - O. Magana) FIELD_STRUCT_DESC: 24-inch corrugated metal gravity drainage pipe through the levee, 11.4 feet below the crown. Flap gate on the waterside (WS) end. Brass cap No. 50 bench mark (BM) on the headwall on the landside (LS). [Additional Reference(s): DWR Levee Log, 2002. USACE San Joaquin O&M Manual 601.1, 1967, (HLM 16.72)]. FS Date: 4/25/2014

View of waterward side.

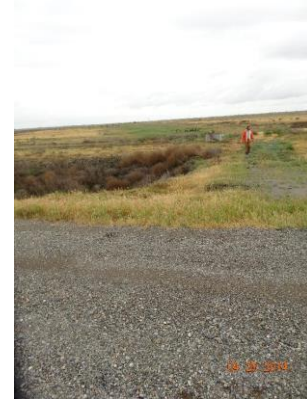
Photo 2 of 2 : UCIP_SP_2019_39360_71486.jpg

LM Start	16.72	Rating **	M	Issue No.	1248 (cont)	
LM End	16.72	Issue Type +	En	Location *		
Category	Supplemental			GPS Latitude/Longitude		
				Start	End	
Item	DWR UCIP Field Study			37.224223 °	37.224223 °	
				-120.783806 °	-120.783806 °	
DWR ID	24870					
Comment Code						
Inspector Comment						
FS_ID:39360 DS_ID:24870 EP_NO: N/A Repair Type: Non-Urgent Crossing Status: Found UCIP Comments: 04/25/2014 Need to contact owner to determine status and reason for crossing. (DWR UCIP - O. Magana) FIELD_STRUCT_DESC: 12-inch steel gravity drainage pipe through the levee, at an unknown depth. Concrete standpipe visible on the landside (LS). This pipe was field discovered. FS Date: 4/25/2014

View of landward side.

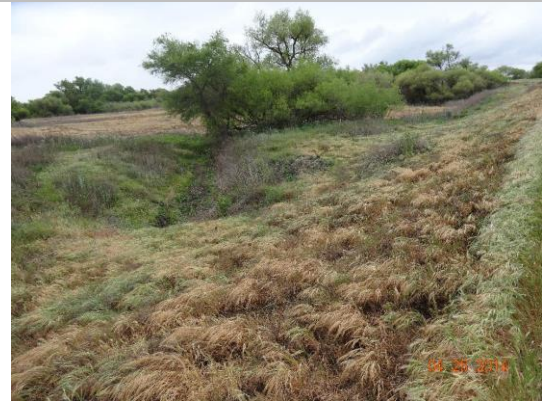
Photo 1 of 3 : UCIP_SP_2019_39259_65518.jpg

Comment Code						
Inspector Comment						
FS_ID:39259 DS_ID:19577 EP_NO: N/A Repair Type: Non-Urgent Crossing Status: Found UCIP Comments: 04/25/2014 Dense vegetation limits the inspector's visibility to identify signs of pipe failure (leaks) along the waterward and landward slopes. Concrete headwall is buried by dense vegetation. Recommend removing vegetation along pipe alignment to conduct proper inspection of structure. (DWR UCIP - O. Magana) FIELD_STRUCT_DESC: 24-inch corrugated metal gravity drainage pipe through the levee, 11.5 feet below the crown. Flap gate on the waterside (WS) end. Brass cap No. 50 bench mark (BM) on the headwall on the landside (LS). [Additional Reference(s): DWR Levee Log, 2002. USACE San Joaquin O&M Manual 601.1, 1967, (HLM 17.01)]. FS Date: 4/25/2014

View of waterward side.

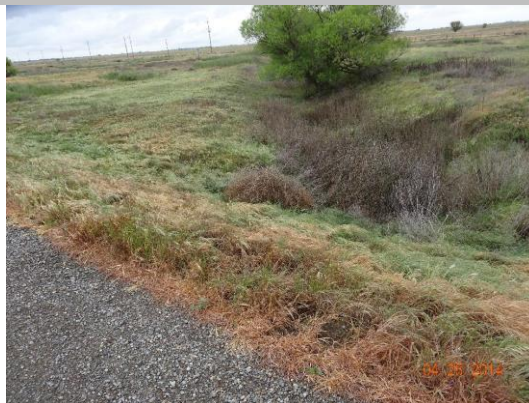
Photo 3 of 3 : UCIP_SP_2019_39259_65517.jpg

View of landward side.

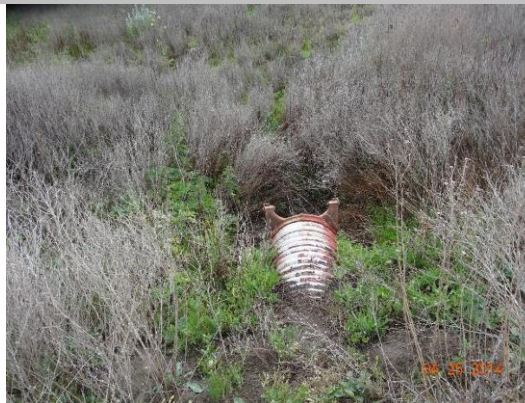
Photo 2 of 3 : UCIP_SP_2019_39260_65521.jpg

Comment Code						
Inspector Comment						
FS_ID:39260 DS_ID:19578 EP_NO: N/A Repair Type: Non-Urgent Crossing Status: Found UCIP Comments: 04/25/2014 Dense vegetation limits the inspector's visibility to identify signs of pipe failure (leaks) along the waterward and landward slopes. Recommend removing vegetation along pipe alignment to conduct proper inspection of structure. Sediment buildup inside pipe visible from landward side. Recommend clearing pipe. (DWR UCIP - O. Magana) FIELD_STRUCT_DESC: 24-inch corrugated metal gravity drainage pipe through the levee, 11.5 feet below the crown. Flap gate on the waterside (WS) end. Brass cap No. 50 bench mark (BM) on the headwall on the landside (LS). [Additional Reference(s): DWR Levee Log, 2002. USACE San Joaquin O&M Manual 601.1, 1967, (HLM 17.19)]. FS Date: 4/25/2014

Pipe visible on waterward side.

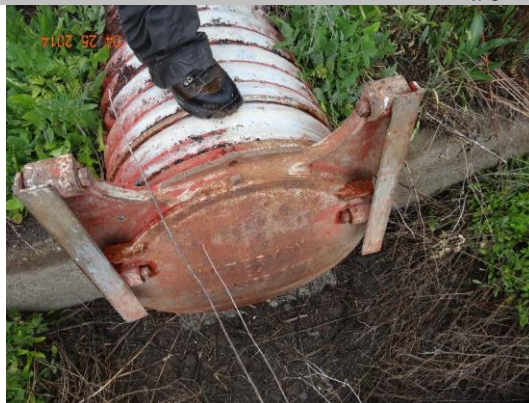
Photo 3 of 3 : UCIP_SP_2019_39260_65520.jpg

Item	DWR UCIP LMA Responsibility			37.219302 °	37.219302 °	
				-120.779475 °	-120.779475 °	
DWR ID	19578					
Comment Code						
Inspector Comment						
FS_ID:39260 DS_ID:19578 EP_NO: N/A Repair Type: Non-Urgent Crossing Status: Found UCIP Comments: 04/25/2014 Dense vegetation limits the inspector's visibility to identify signs of pipe failure (leaks) along the waterward and landward slopes. Recommend removing vegetation along pipe alignment to conduct proper inspection of structure. Sediment buildup inside pipe visible from landward side. Recommend clearing pipe. (DWR UCIP - O. Magana) FIELD_STRUCT_DESC: 24-inch corrugated metal gravity drainage pipe through the levee, 11.5 feet below the crown. Flap gate on the waterside (WS) end. Brass cap No. 50 bench mark (BM) on the headwall on the landside (LS). [Additional Reference(s): DWR Levee Log, 2002. USACE San Joaquin O&M Manual 601.1, 1967, (HLM 17.19)]. FS Date: 4/25/2014

Flap gate visible on waterward toe.

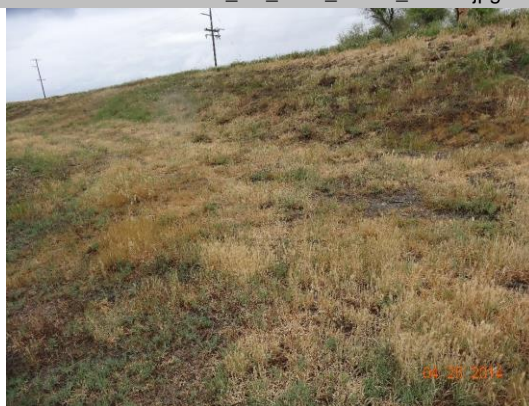
Photo 1 of 3 : UCIP_SP_2019_36203_65551.jpg

Comment Code					
Inspector Comment					
FS_ID:36203 DS_ID:19579 EP_NO: N/A Repair Type: Non-Urgent Crossing Status: Found UCIP Comments: 04/25/2014 Dense vegetation limits the inspector's visibility to identify signs of pipe failure (leaks) along the waterward and landward slope. Recommend removing vegetation along pipe alignment to conduct proper inspection of structure. (DWR UCIP - O. Magana) FIELD_STRUCT_DESC: 24-inch corrugated metal gravity drainage pipe through the levee, 15.8 feet below the crown. Flap gate on the waterside (WS) end. Brass cap No. 50 bench mark (BM) on the headwall on the landside (LS). [Additional Reference(s): DWR Levee Log, 2002. USACE San Joaquin O&M Manual 601.1, 1967, (HLM 17.26)]. FS Date: 4/25/2014

View of waterward slope.

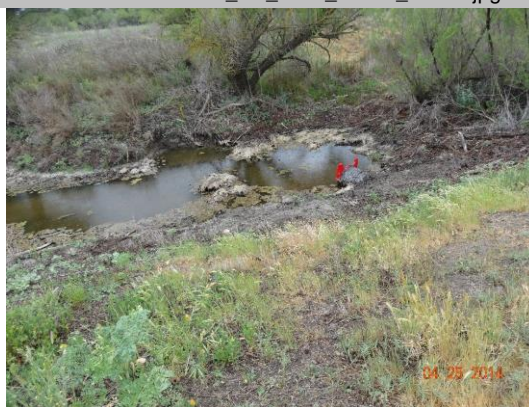
Photo 2 of 3 : UCIP_SP_2019_36203_65552.jpg

LM Start	17.26	Rating **	M	Issue No.	1251 (cont)
LM End	17.26	Issue Type +	Ma	Location *

Pipe visible on waterward side.

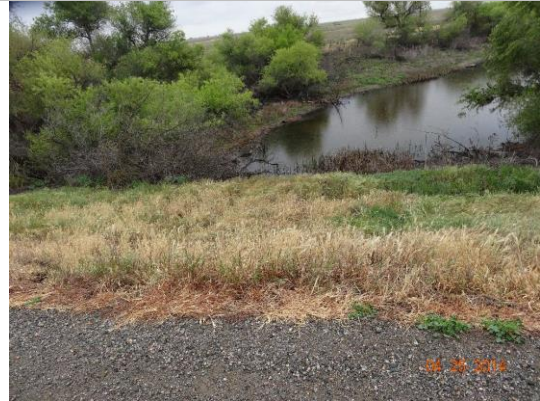
Photo 3 of 3 : UCIP_SP_2019_36203_65554.jpg

Item	DWR UCIP LMA Responsibility			37.218332 °		37.218332 °
				-120.779459 °		-120.779459 °
DWR ID	19579					
Comment Code						
Inspector Comment						
FS_ID:36203 DS_ID:19579 EP_NO: N/A Repair Type: Non-Urgent Crossing Status: Found UCIP Comments: 04/25/2014 Dense vegetation limits the inspector's visibility to identify signs of pipe failure (leaks) along the waterward and landward slope. Recommend removing vegetation along pipe alignment to conduct proper inspection of structure. (DWR UCIP - O. Magana) FIELD_STRUCT_DESC: 24-inch corrugated metal gravity drainage pipe through the levee, 15.8 feet below the crown. Flap gate on the waterside (WS) end. Brass cap No. 50 bench mark (BM) on the headwall on the landside (LS). [Additional Reference(s): DWR Levee Log, 2002. USACE San Joaquin O&M Manual 601.1, 1967, (HLM 17.26)]. FS Date: 4/25/2014

View of landward side.

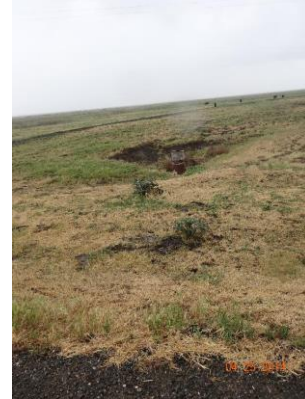
Photo 3 of 3 : UCIP_SP_2019_39261_65555.jpg

Item	DWR UCIP LMA Responsibility			37.210998 °	37.210998 °	
				-120.768900 °	-120.768900 °	
DWR ID	19581					
Comment Code						
Inspector Comment						
FS_ID:39261 DS_ID:19581 EP_NO: N/A Repair Type: Non-Urgent Crossing Status: Found UCIP Comments: 04/25/2014 Need to contact owner. Recommend investigating integrity of pipe wall through levee heavy corrosion visible from landward side. (DWR UCIP - O. Magana) FIELD_STRUCT_DESC: 24-inch corrugated metal gravity drainage pipe through the levee, 11.5 feet below the crown. Flap gate on the waterside (WS) end. Brass cap No. 50 bench mark (BM) on the headwall on the landside (LS). [Additional Reference(s): DWR Levee Log, 2002. USACE San Joaquin O&M Manual 601.1, 1967, (HLM 18.19)]. FS Date: 4/25/2014

View of landward side.

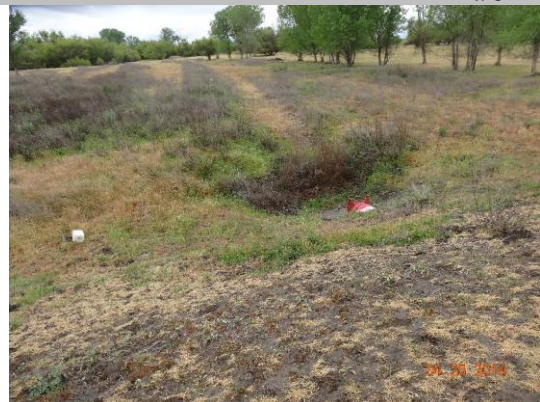
Photo 1 of 3 : UCIP_SP_2019_36206_65563.jpg

LM Start	18.45	Rating **	A/W	Issue No.	1254	
LM End	18.45	Issue Type +	Ma	Location *		
Category	Supplemental			GPS Latitude/Longitude		
				Start	End	
Item	DWR UCIP LMA Responsibility			37.207538 °	37.207538 °	
				-120.767679 °	-120.767679 °	
DWR ID	19582					
Comment Code						
Inspector Comment						
FS_ID:36206						
DS_ID:19582						
EP_NO: N/A						
Repair Type: No Action Needed						
Crossing Status: Found						
UCIP Comments:						
FIELD_STRUCT_DESC: 24-inch corrugated metal gravity drainage pipe through the levee, 9.4 feet below the crown. Flap gate on the waterside (WS) end. Brass cap No. 50 bench mark (BM) on the headwall on the landside (LS). [Additional Reference(s): DWR Levee Log, 2002. USACE San Joaquin O&M Manual 601.1, 1967, (HLM 18.45)].						
FS Date: 4/25/2014

View of waterward side.

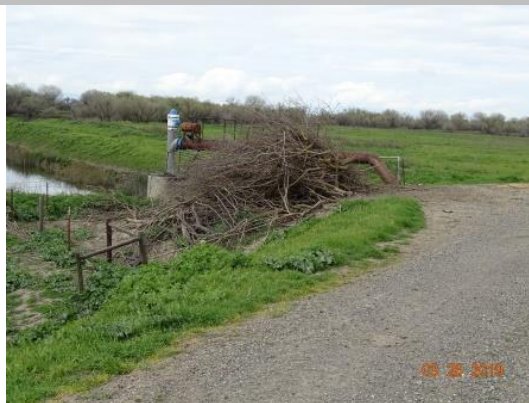
Photo 1 of 1 : SP_2019_NA0010_118_134_20190402_00290.jpg

LM Start	18.77	Rating **	U	Issue No.	134
LM End	18.77	Issue Type +	En	Location *	WS
Category	Earthen Levee			GPS Latitude/Longitude	
				Start	End
Item	Encroachments			37.205064 °	37.205064 °
				-120.762721 °	-120.762721 °
DWR ID	DWR_NA0010_01_s_2019_134				
Comment Code					
PR : Prunings					
Inspector Comment

View of prunings on waterside slope. (Spring 2019)

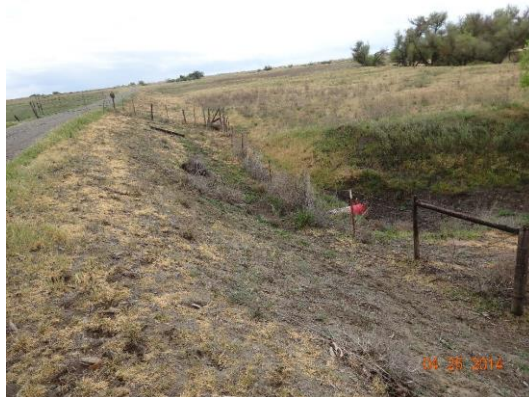
Photo 2 of 3 : UCIP_SP_2019_36246_65623.jpg

Item	DWR UCIP LMA Responsibility			37.204966 °	37.204966 °	
				-120.762511 °	-120.762511 °	
DWR ID	19593					
Comment Code						
Inspector Comment						
FS_ID:36246						
DS_ID:19593						
EP_NO: N/A						
Repair Type: Non-Urgent						
Crossing Status: Found						
UCIP Comments: 04/25/2014 Dense vegetation limits the inspector's visibility to identify signs of pipe failure (leaks) along the landward slope. Recommend removing vegetation along pipe alignment to conduct proper inspection of structure. (DWR UCIP - O. Magana)						
FIELD_STRUCT_DESC: 24-inch corrugated metal gravity drainage pipe through the levee, 12 feet below the crown. Flap gate on the waterside (WS) end. Brass cap No. 50 bench mark (BM) on the headwall on the landside (LS). [Additional Reference(s): DWR Levee Log, 2002. USACE San Joaquin O&M Manual 601.1, 1967, (HLM 18.79)].						
FS Date: 4/25/2014

View of waterward side.

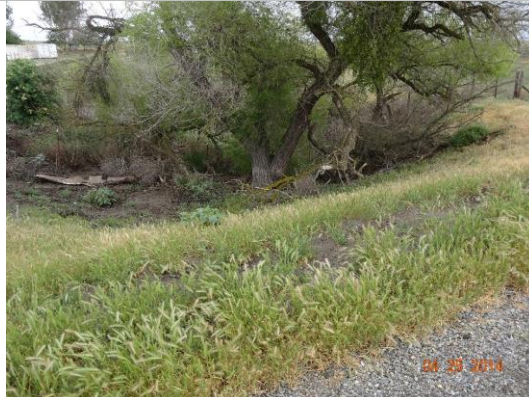
Photo 3 of 3 : UCIP_SP_2019_36246_65626.jpg

Overview of landward side.

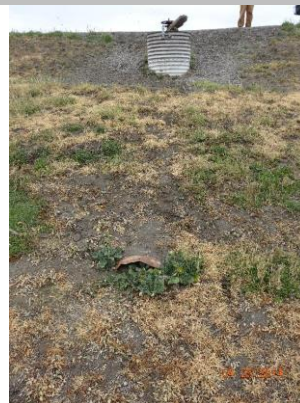
Photo 1 of 3 : UCIP_SP_2019_39263_65631.jpg

Comment Code					
Inspector Comment					
FS_ID:39263					
DS_ID:19594					
EP_NO: N/A					
Repair Type: Non-Urgent					
Crossing Status: Found					
UCIP Comments: 04/25/2014 Non-functional crossing--pipe is buried on waterward side. Sediment buildup in pipe visible from landward side. Need to coordinate with owner to determine status. If crossing is no longer in use, owner will need to coordinate with DWR Inspector and CVFPB to properly abandon. (DWR UCIP - O. Magana)					
FIELD_STRUCT_DESC: 24-inch corrugated metal gravity drainage pipe through the levee, 13 feet below the crown. Flap gate on the waterside (WS) end. Brass cap No. 40 bench mark (BM) on the headwall on the landside (LS). [Additional Reference(s): DWR Levee Log, 2002. USACE San Joaquin O&M Manual 601.1, 1967, (HLM 19.17)].					
FS Date: 4/25/2014

View of waterward slope. CMP riser and pipe visible.

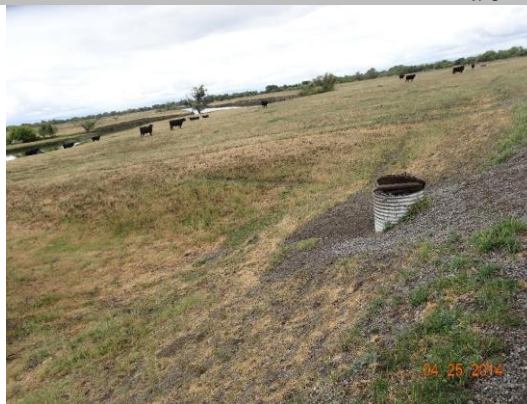
Photo 2 of 3 : UCIP_SP_2019_39263_65630.jpg

View of waterward side.

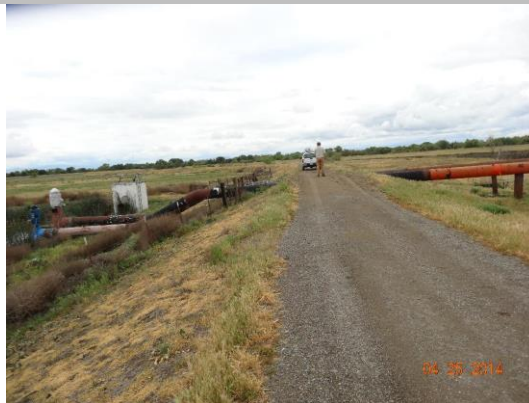
Photo 2 of 3 : UCIP_SP_2019_39266_71420.jpg

Overview of levee crown at crossing.

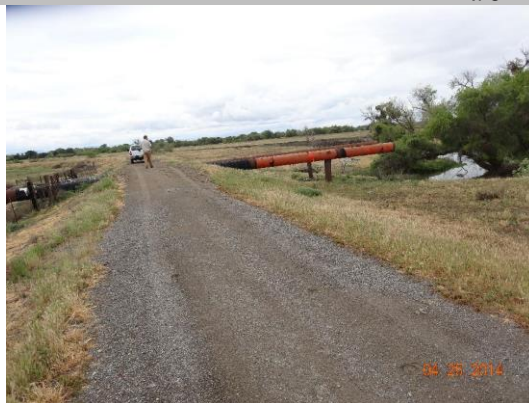
Photo 3 of 3 : UCIP_SP_2019_39266_71423.jpg

LM Start	19.32	Rating **	M	Issue No.	1257 (cont)	
LM End	19.32	Issue Type +	En	Location *		
Category	Supplemental			GPS Latitude/Longitude		
				Start		End
Item	DWR UCIP Field Study			37.200921 °		37.200921 °
				-120.756901 °		-120.756901 °
DWR ID	24871					
Comment Code						
Inspector Comment						
FS_ID:39266						
DS_ID:24871						
EP_NO: N/A						
Repair Type: Non-Urgent						
Crossing Status: Found						
UCIP Comments: 04/25/2014 New crossing found during field inspection--Need to contact owner to obtain additional information about crossing. (DWR UCIP - O. Magana)						
FIELD_STRUCT_DESC: 1 of 2: 20-inch steel drainage discharge pipe through the levee, at an unknown depth. Pump station and electrical panel on the landside (LS). This pipe was field discovered.						
FS Date: 4/25/2014

View of waterward slope.

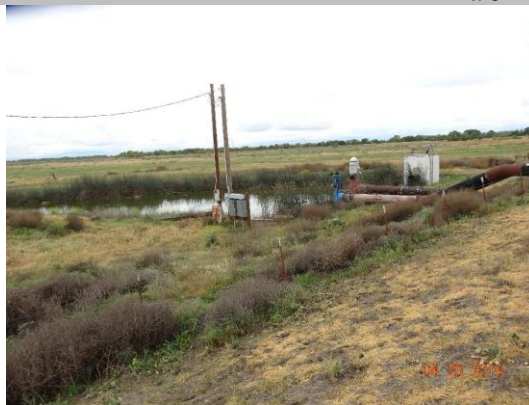
Photo 1 of 3 : UCIP_SP_2019_39267_71427.jpg

LM Start	19.32	Rating **	M	Issue No.	1258	
LM End	19.32	Issue Type +	En	Location *		
Category	Supplemental			GPS Latitude/Longitude		
				Start	End	
Item	DWR UCIP Field Study			37.200919 °	37.200919 °	
				-120.756928 °	-120.756928 °	
DWR ID	24872					
Comment Code						
Inspector Comment						
FS_ID:39267 DS_ID:24872 EP_NO: N/A Repair Type: Non-Urgent Crossing Status: Found UCIP Comments: 04/25/2014 New crossing found during field inspection--Need to contact owner to obtain additional information about crossing. (DWR UCIP - O. Magana) FIELD_STRUCT_DESC: 2 of 2: 20-inch steel drainage discharge pipe through the levee, at an unknown depth. Pump station and electrical panel on the landside (LS). This pipe was field discovered. FS Date: 4/25/2014

View of landward side.

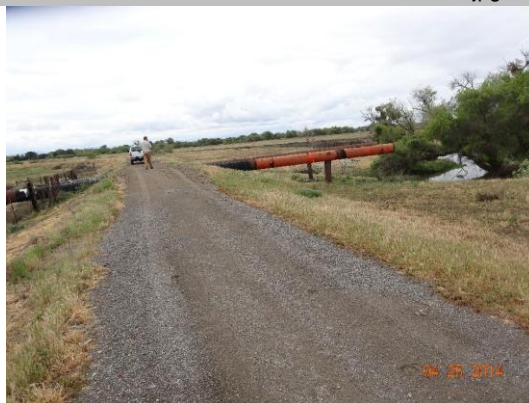
Photo 3 of 3 : UCIP_SP_2019_39267_71424.jpg

View of waterward slope.

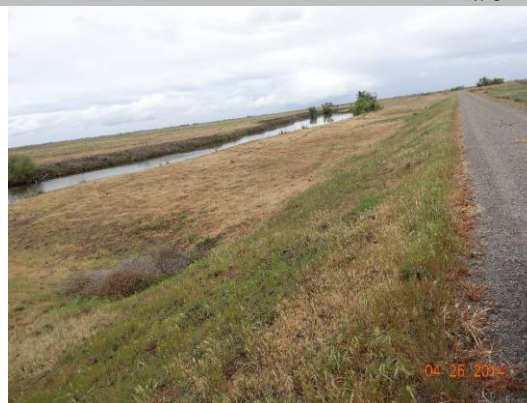
Photo 1 of 3 : UCIP_SP_2019_39268_65641.jpg

Comment Code					
Inspector Comment					
FS_ID:39268 DS_ID:19596 EP_NO: N/A Repair Type: Non-Urgent Crossing Status: Found UCIP Comments: 04/25/2014 Dense vegetation limits the inspector's visibility to identify signs of pipe failure (leaks) along the waterward slope. Recommend removing vegetation along pipe alignment to conduct proper inspection of structure. Dense vegetation blocks both waterward and landward headwalls. Sediment buildup in pipe visible from landward side. (DWR UCIP - O. Magana) FIELD_STRUCT_DESC: 24-inch corrugated metal gravity drainage pipe through the levee, 8 feet below the crown. Flap gate on the waterside (WS) end. Brass cap No. 40 bench mark (BM) on the headwall on the landside (LS). [Additional Reference(s): DWR Levee Log, 2002. USACE San Joaquin O&M Manual 601.1, 1967, (HLM 19.54)]. FS Date: 4/25/2014

View of waterward side.

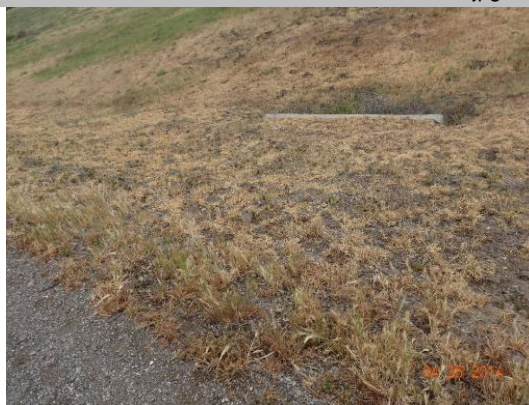
Photo 3 of 3 : UCIP_SP_2019_39268_65639.jpg

View of landward slope.

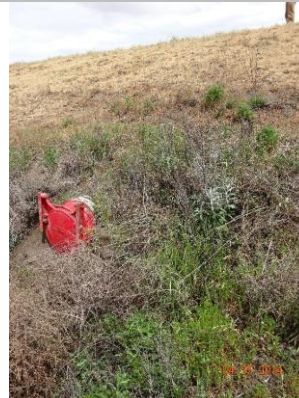
Photo 2 of 3 : UCIP_SP_2019_39269_65647.jpg

Flap gate visible on WS toe.

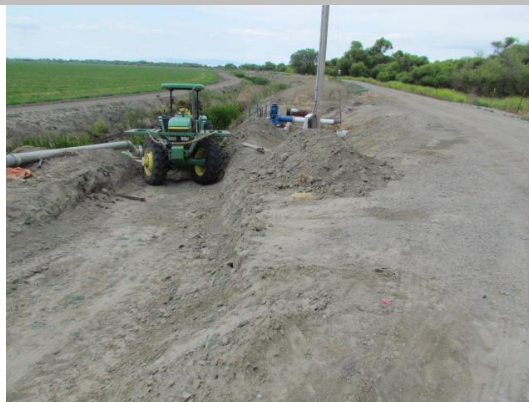
Photo 1 of 2 : SP_2019_NA0010_118_1184_20190307_00045.jpg

LM Start	20.25	Rating **	U	Issue No.	1184
LM End	20.25	Issue Type +	En	Location *	LS
Category	Earthen Levee			GPS Latitude/Longitude	
				Start	End
Item	Encroachments			37.193657 °	37.193657 °
				-120.760138 °	-120.760138 °
DWR ID	DWR_NA0010_01_s_2015_1184				
Comment Code					
RA : Ramp					
Inspector Comment					
Landowner installed unauthorized ramp on landside slope and toe.

Looking north at ramp cut into landward slope.

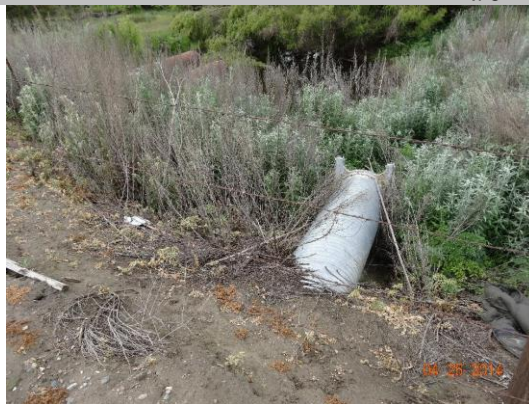
Photo 2 of 3 : UCIP_SP_2019_49965_66304.jpg

View of WS.

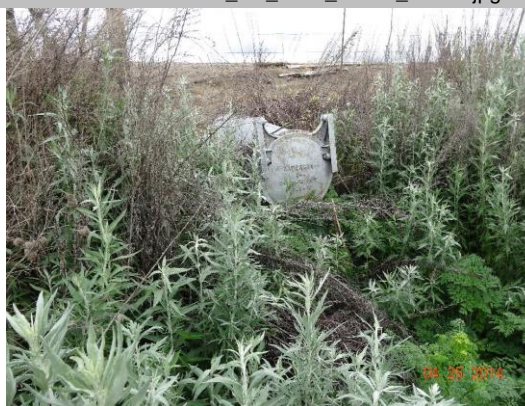
Photo 3 of 3 : UCIP_SP_2019_49965_66302.jpg

Item	DWR UCIP Field Study			37.193542 °	37.193542 °	
				-120.760300 °	-120.760300 °	
DWR ID	19599					
Comment Code						
Inspector Comment						
FS_ID:49965 DS_ID:19599 EP_NO: N/A Repair Type: Non-Urgent Crossing Status: Found UCIP Comments: 7/19/2016 same as previous inspection. crossing was downgraded from Urgent to Non-Urgent due to metal rod not interfering with flap gate. (DWR UCIP - omagana)4/25/2014 Unauthorized crossing through pipe. Line was pushed through existing crossing. Need to contact owner. Also sediment buildup in pipe visible from landward side--recommend clearing. (DWR UCIP - O. Magana) FIELD_STRUCT_DESC: 24-inch corrugated metal gravity drainage pipe through the levee, 5 feet below the crown. Flap gate on the waterside (WS) end. No permit for this crossing. [Additional Reference(s): DWR Levee Log, 2002]. FS Date: 7/19/2016

View of WS.

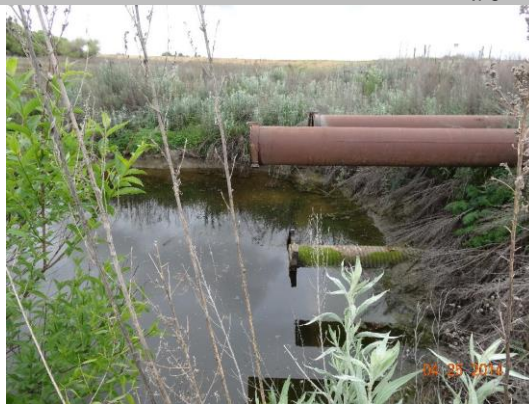
Photo 2 of 3 : UCIP_SP_2019_39878_66309.jpg

Comment Code					
Inspector Comment					
FS_ID:39878 DS_ID:19600 EP_NO: N/A Repair Type: Non-Urgent Crossing Status: Found UCIP Comments: 04/25/2014 Crossing partially submersed--no signs of failure of pipe present along pipe alignment. Recommend contacting owner to determine status of crossing and condition. (DWR UCIP - O. Magana) FIELD_STRUCT_DESC: 36-inch corrugated metal gravity drainage pipe through the levee, 10.5 feet below the crown. Flap gate on the waterside (WS) end. Brass cap No. 40 bench mark (BM) on the headwall on the landside (LS). [Additional Reference(s): DWR Levee Log, 2002. USACE San Joaquin O&M Manual 601.1, 1967, (HLM 20.27)]. FS Date: 4/25/2014

Multiple crossings visible on waterward side--36 inch CMP is submersed in water.

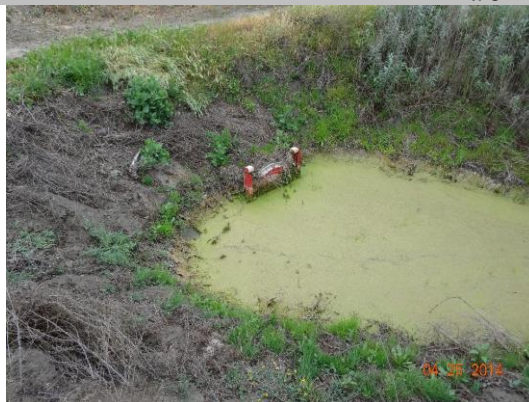
Photo 2 of 3 : UCIP_SP_2019_39271_66313.jpg

Flap gate half way submersed located on waterward side.

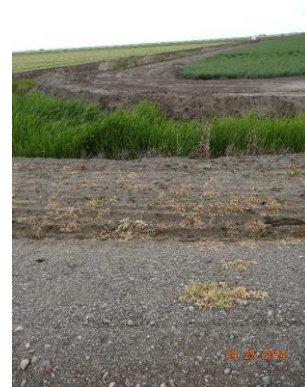
Photo 3 of 3 : UCIP_SP_2019_39271_66311.jpg

Item	DWR UCIP LMA Responsibility			37.179065 °	37.179065 °	
				-120.761567 °	-120.761567 °	
DWR ID	19603					
Comment Code						
Inspector Comment						
FS_ID:39271 DS_ID:19603 EP_NO: N/A Repair Type: Non-Urgent Crossing Status: Found UCIP Comments: 04/25/2014 Crossing is non-functional--crossing buried on landward side. Need to contact owner to determine status of crossing. If crossing is no longer used need to coordinate with CVFPB for proper abandonment. (DWR UCIP - O. Magana) FIELD_STRUCT_DESC: 36-inch corrugated metal gravity drainage pipe through the levee, 11.5 feet below the crown. Flap gate on the waterside (WS) end. Brass cap No. 40 bench mark (BM) on the headwall on the landside (LS). [Additional Reference(s): DWR Levee Log, 2002. USACE San Joaquin O&M Manual 601.1, 1967, (HLM 21.40)]. FS Date: 4/25/2014

View of landward side.

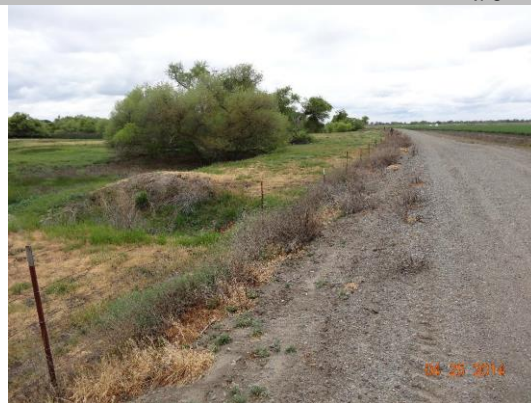
Photo 1 of 3 : UCIP_SP_2019_39272_65697.jpg

Comment Code						
Inspector Comment						
FS_ID:39272 DS_ID:19604 EP_NO: N/A Repair Type: Non-Urgent Crossing Status: Found UCIP Comments: 04/25/2014 Non-functional crossing-landward side is buried. Need to contact owner to determine status of crossing. If crossing is no longer used need to coordinate with CVFPB for proper abandonment. (DWR UCIP - O. Magana) FIELD_STRUCT_DESC: 24-inch corrugated metal gravity drainage pipe through the levee, 9 feet below the crown. Flap gate on the waterside (WS) end. Brass cap No. 40 bench mark (BM) on the headwall on the landside (LS). [Additional Reference(s): DWR Levee Log, 2002. USACE San Joaquin O&M Manual 601.1, 1967, (HLM 21.76)]. FS Date: 4/25/2014

View of waterward side.

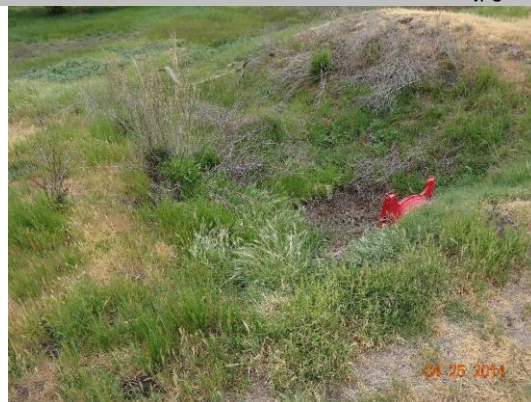
Photo 2 of 3 : UCIP_SP_2019_39272_65695.jpg

Flap gate visible on waterward side.

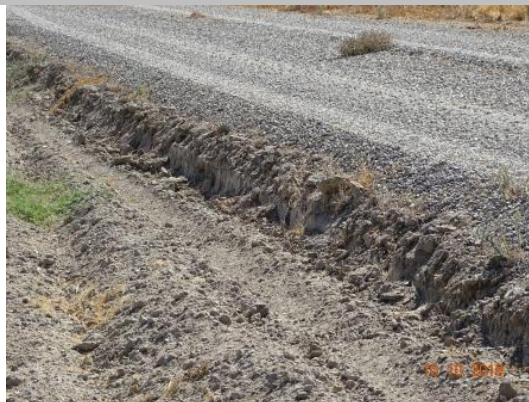
Photo 1 of 2 : SP_2019_NA0010_118_130_20190307_00043.jpg

LM Start	21.99	Rating **	M	Issue No.	130
LM End	22.01	Issue Type +	En	Location *	LS
Category	Earthen Levee			GPS Latitude/Longitude	
				Start	End
Item	Encroachments			37.173001 °	37.172668 °
				-120.755115 °	-120.754933 °
DWR ID	DWR_NA0010_01_f_2018_130				
Comment Code					
AT : Agricultural tilling					
Inspector Comment					
Tilling along landside toe partially cut into the slope.

View of tilling from toe looking towards the levee. (Fall 2018)

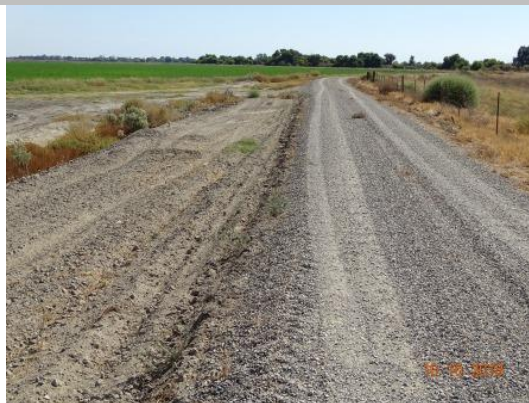
Photo 2 of 2 : SP_2019_NA0010_118_130_20190307_00044.jpg

LM Start	21.99	Rating **	M	Issue No.	130 (cont)	
LM End	22.01	Issue Type +	En	Location *	LS	
Category	Earthen Levee			GPS Latitude/Longitude		
				Start		End
Item	Encroachments			37.173001 °		37.172668 °
				-120.755115 °		-120.754933 °
DWR ID	DWR_NA0010_01_f_2018_130					
Comment Code						
AT : Agricultural tilling						
Inspector Comment						
Tilling along landside toe partially cut into the slope.

View of tilling looking upstream. (Fall 2018)

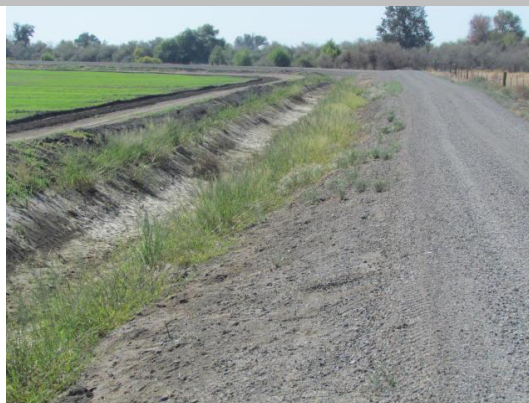
Photo 1 of 3 : SP_2019_NA0010_118_22_20190307_00012.jpg

LM Start	22.06	Rating **	U	Issue No.	22
LM End	22.52	Issue Type +	En	Location *	LS
Category	Earthen Levee			GPS Latitude/Longitude	
				Start	End
Item	Encroachments			37.172074 °	37.166906 °
				-120.754628 °	-120.749962 °
DWR ID	DWR_NA0010_01_s_2012_22				
Comment Code					
DT : Ditch					
Inspector Comment					
Ditch has encroached into landside toe and slope.

Looking downstream at irrigation ditch at LM 22.06

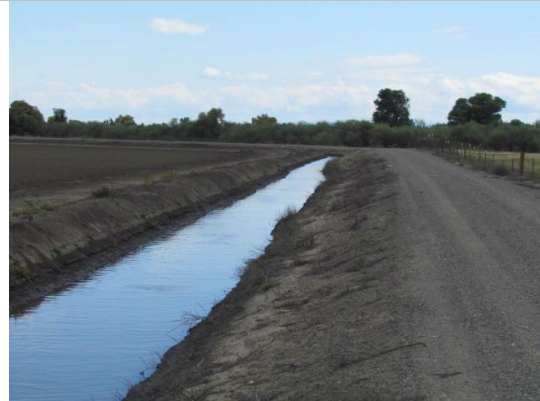
Photo 3 of 3 : SP_2019_NA0010_118_22_20190307_00014.jpg

LM Start	22.06	Rating **	U	Issue No.	22 (cont)	
LM End	22.52	Issue Type +	En	Location *	LS	
Category	Earthen Levee			GPS Latitude/Longitude		
				Start	End	
Item	Encroachments			37.172074 °	37.166906 °	
				-120.754628 °	-120.749962 °	
DWR ID	DWR_NA0010_01_s_2012_22					
Comment Code						
DT : Ditch						
Inspector Comment						
Ditch has encroached into landside toe and slope.

Looking upstream at irrigation at landside toe.

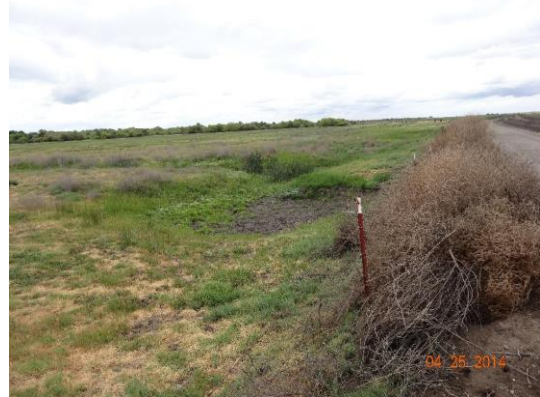
Photo 1 of 3 : UCIP_SP_2019_39273_65709.jpg

Comment Code						
Inspector Comment						
FS_ID:39273						
DS_ID:19605						
EP_NO: N/A						
Repair Type: Non-Urgent						
Crossing Status: Found						
UCIP Comments: 04/25/2014 Non-functional crossing--landward side is buried. Need to contact owner to determine status. If crossing is no longer used need to coordinate with CVFPB for proper abandonment. (DWR UCIP - O. Magana)						
FIELD_STRUCT_DESC: 24-inch corrugated metal gravity drainage pipe through the levee, 9 feet below the crown. Flap gate on the waterside (WS) end. Wooden headboards on the landside (LS) end. Brass cap No. 31 bench mark (BM) on the headwall on the LS. [Additional Reference(s): DWR Levee Log, 2002. USACE San Joaquin O&M Manual 601.1, 1967, (HLM 22.13)].						
FS Date: 4/25/2014

View of waterward side.

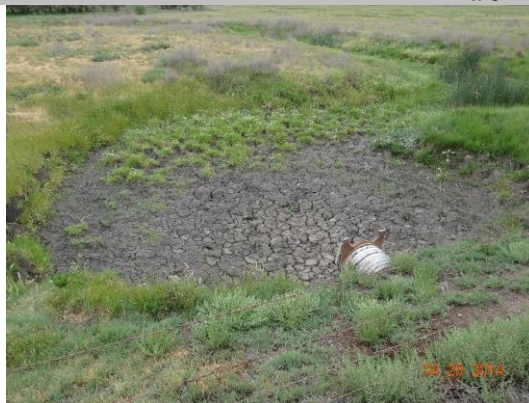
Photo 2 of 3 : UCIP_SP_2019_39273_65707.jpg

Item	DWR UCIP LMA Responsibility			37.171181°	37.171181°	
				-120.754526°	-120.754526°	
DWR ID	19605					
Comment Code						
Inspector Comment						
FS_ID:39273						
DS_ID:19605						
EP_NO: N/A						
Repair Type: Non-Urgent						
Crossing Status: Found						
UCIP Comments: 04/25/2014 Non-functional crossing--landward side						
is buried. Need to contact owner to determine status. If crossing is no						
longer used need to coordinate with CVFPB for proper abandonment.						
(DWR UCIP - O. Magana)						
FIELD_STRUCT_DESC: 24-inch corrugated metal gravity drainage pipe						
through the levee, 9 feet below the crown. Flap gate on the waterside						
(WS) end. Wooden headboards on the landside (LS) end. Brass cap						
No. 31 bench mark (BM) on the headwall on the LS. [Additional						
Reference(s): DWR Levee Log, 2002. USACE San Joaquin O&M						
Manual 601.1, 1967, (HLM 22.13)].						
FS Date: 4/25/2014

Flap gate visible on waterward side.

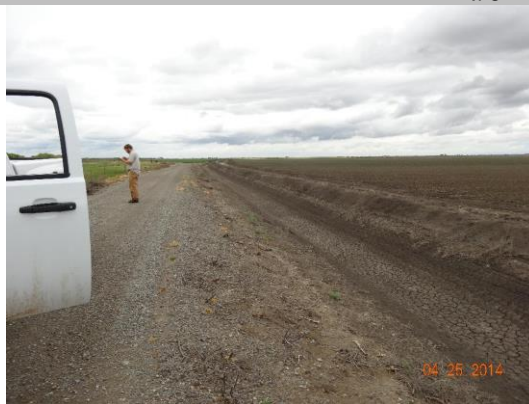
Photo 3 of 3 : UCIP_SP_2019_39273_65708.jpg

View of landward side.

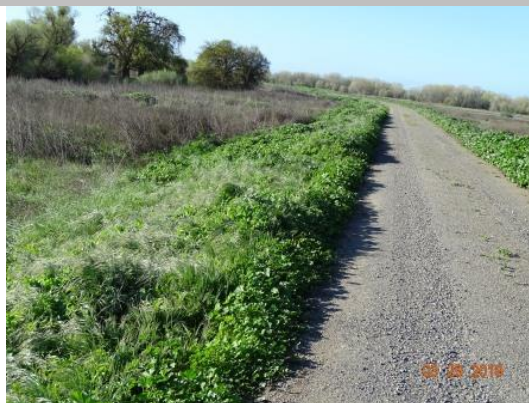
Photo 1 of 1 : SP_2019_NA0010_119_37_20190415_00079.jpg

LM Start	0.00	Rating **	U	Issue No.	37
LM End	7.83	Issue Type +	Ma	Location *	WS
Category	Earthen Levee			GPS Latitude/Longitude	
				Start	End
Item	Vegetation			37.296277 °	37.231638 °
				-120.880669 °	-120.812247 °
DWR ID	DWR_NA0010_02A_s _ 2019_37				
Comment Code					
V1 : Control annual grass and weeds on the levee slopes and easements.					
Inspector Comment

View of waterside slope looking upstream. (Spring 2019)

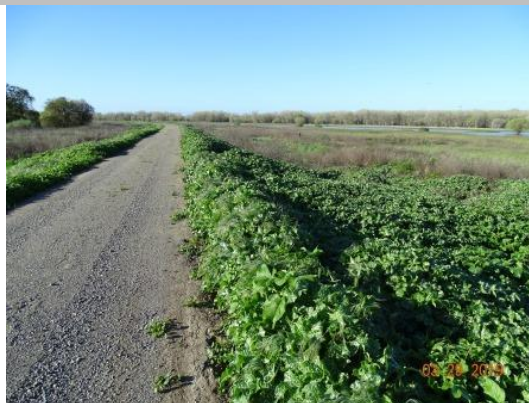
Photo 1 of 1 : SP_2019_NA0010_119_38_20190415_00078.jpg

LM Start	0.00	Rating **	U	Issue No.	38
LM End	7.83	Issue Type +	Ma	Location *	LS
Category	Earthen Levee			GPS Latitude/Longitude	
				Start	End
Item	Vegetation			37.296294 °	37.231638 °
				-120.880625 °	-120.812247 °
DWR ID	DWR_NA0010_02A_s _ 2019_38				
Comment Code					
V1 : Control annual grass and weeds on the levee slopes and easements.					
Inspector Comment

View of landside slope looking upstream. (Spring 2019)

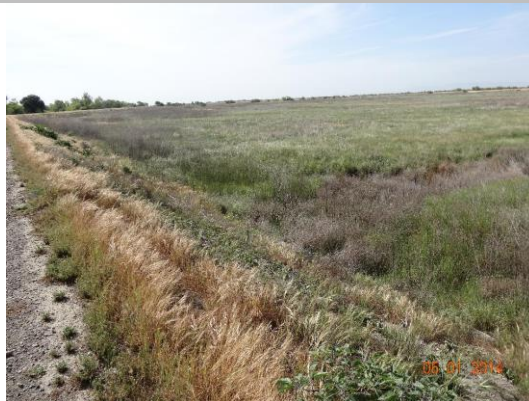
Photo 3 of 3 : UCIP_SP_2019_36503_66100.jpg

Comment Code						
Inspector Comment						
FS_ID:36503 DS_ID:19652 EP_NO: N/A Repair Type: Non-Urgent Crossing Status: Found UCIP Comments: 05/01/2014 Dense vegetation limits the inspector's visibility to identify signs of pipe failure (leaks) along the slope. Recommend removing vegetation along pipe alignment to conduct proper inspection of structure. (DWR UCIP - O. Magana) FIELD_STRUCT_DESC: 24-inch corrugated metal gravity drainage pipe through the levee, 11 feet below the crown. Flap gate on the waterside (WS) end. Brass cap No. 139 bench mark (BM) on the headwall on the landside (LS). [Additional Reference(s): DWR Levee Log, 2002. USACE San Joaquin O&M Manual 601.1, 1967, (HLM 0.24)]. FS Date: 5/1/2014

View of landward side.

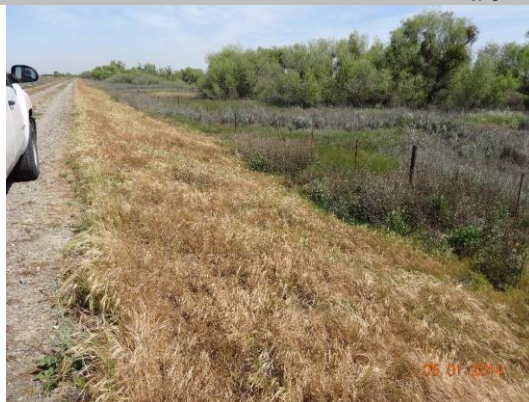
Photo 1 of 3 : UCIP_SP_2019_36504_66106.jpg

Comment Code						
Inspector Comment						
FS_ID:36504 DS_ID:19653 EP_NO: N/A Repair Type: Non-Urgent Crossing Status: Found UCIP Comments: 05/01/2014 Dense vegetation limits the inspector's visibility to identify signs of pipe failure (leaks) along the slope. Recommend removing vegetation along pipe alignment to conduct proper inspection of structure. (DWR UCIP - O. Magana) FIELD_STRUCT_DESC: 24-inch corrugated metal gravity drainage pipe through the levee, 14.8 feet below the crown. Flap gate on the waterside (WS) end. Brass cap No. 138 bench mark (BM) on the headwall on the landside (LS). [Additional Reference(s): DWR Levee Log, 2002. USACE San Joaquin O&M Manual 601.1, 1967, (HLM 0.67)]. FS Date: 5/1/2014

View of waterward side.

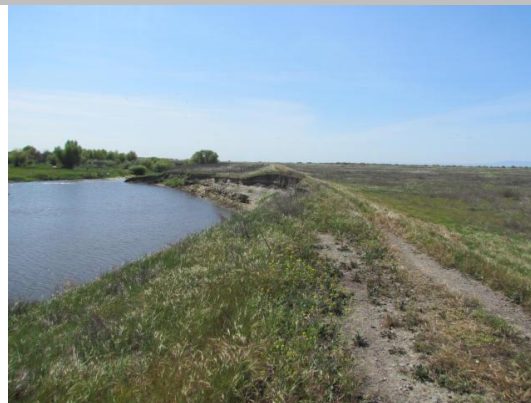
Photo 1 of 4 : SP_2019_NA0010_119_5_20190307_00005.jpg

LM Start	0.71	Rating **	U	Issue No.	5
LM End	0.78	Issue Type +	Ma	Location *	WS
Category	Earthen Levee			GPS Latitude/Longitude	
				Start	End
Item	Erosion / Bank Caving			37.287517 °	37.286543 °
				-120.874583 °	-120.873935 °
DWR ID	DWR_NA0010_02A_s_2012_5				
Comment Code					
E2 : Schedule repair of erosion site prior to the next inspection.					
Inspector Comment					
This levee unit is in the process of being turned over to State Parks.

Looking south at large erosion on waterside slope. (Spring 2012)

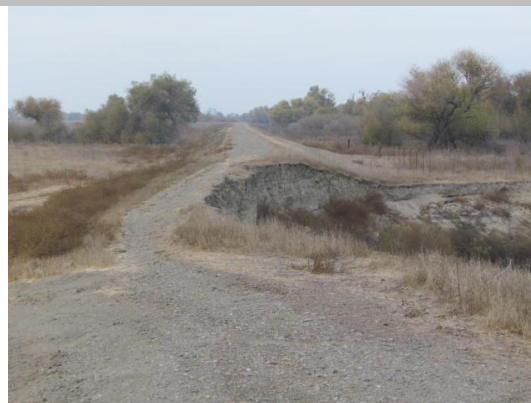
Photo 2 of 4 : SP_2019_NA0010_119_5_20190307_00006.jpg

Looking north at large erosion on waterward slope. (Fall 2013)

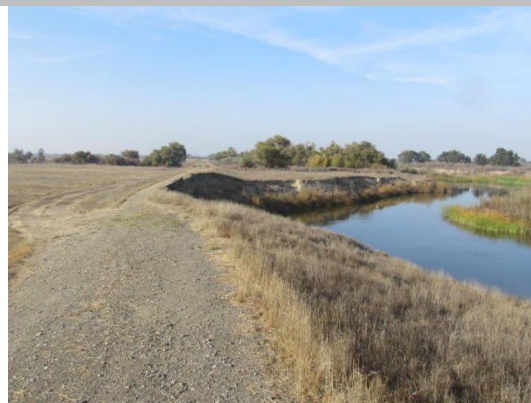
Photo 3 of 4 : SP_2019_NA0010_119_5_20190307_00007.jpg

Looking north at erosion on waterward slope. (Fall 2014)

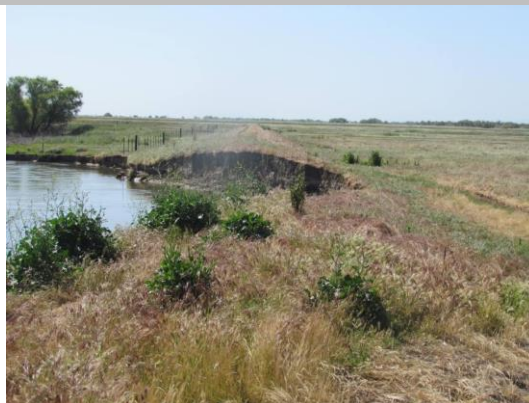
Photo 4 of 4 : SP_2019_NA0010_119_5_20190307_00008.jpg

LM Start	0.71	Rating **	U	Issue No.	5 (cont)	
LM End	0.78	Issue Type +	Ma	Location *	WS	
Category	Earthen Levee			GPS Latitude/Longitude		
				Start		End
Item	Erosion / Bank Caving			37.287517 °		37.286543 °
				-120.874583 °		-120.873935 °
DWR ID	DWR_NA0010_02A_s_2012_5					
Comment Code						
E2 : Schedule repair of erosion site prior to the next inspection.						
Inspector Comment						
This levee unit is in the process of being turned over to State Parks.

Looking upstream at erosion fall 2017.

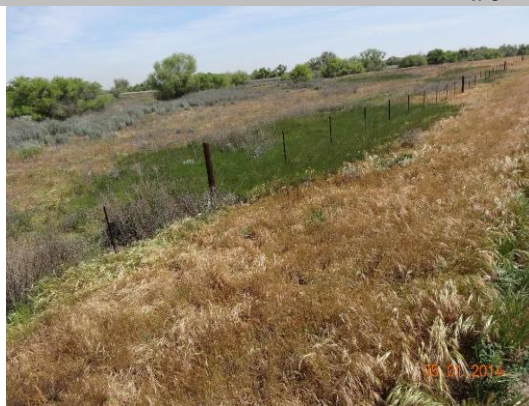
Photo 1 of 3 : UCIP_SP_2019_39363_66113.jpg

Comment Code					
Inspector Comment					
FS_ID:39363 DS_ID:19654 EP_NO: N/A Repair Type: Non-Urgent Crossing Status: Found UCIP Comments: 05/01/2014 Dense vegetation limits the inspector's visibility to identify signs of pipe failure (leaks) along the slope. Recommend removing vegetation along pipe alignment to conduct proper inspection of structure. Sediment buildup in pipe recommend clearing. (DWR UCIP - O. Magana) FIELD_STRUCT_DESC: 24-inch corrugated metal gravity drainage pipe through the levee, 8.6 feet below the crown. Flap gate on the waterside (WS) end. Brass cap No. 137 bench mark (BM) on the headwall on the landside (LS). [Additional Reference(s): DWR Levee Log, 2002. USACE San Joaquin O&M Manual 601.1, 1967, (HLM 1.02)]. FS Date: 5/1/2014

View of waterward side.

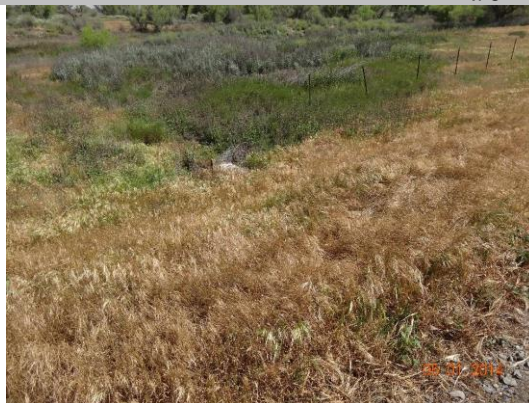
Photo 1 of 3 : UCIP_SP_2019_36506_66114.jpg

Comment Code					
Inspector Comment					
FS_ID:36506 DS_ID:19655 EP_NO: N/A Repair Type: Non-Urgent Crossing Status: Found UCIP Comments: 05/01/2014 Dense vegetation limits the inspector's visibility to identify signs of pipe failure (leaks) along the slope. Recommend removing vegetation along pipe alignment to conduct proper inspection of structure. (DWR UCIP - O. Magana) FIELD_STRUCT_DESC: 24-inch corrugated metal gravity drainage pipe through the levee, 8.6 feet below the crown. Flap gate on the waterside (WS) end. Brass cap No. 136 bench mark (BM) on the headwall on the landside (LS). [Additional Reference(s): DWR Levee Log, 2002. USACE San Joaquin O&M Manual 601.1, 1967, (HLM 1.22)]. FS Date: 5/1/2014

Overview of waterward side.

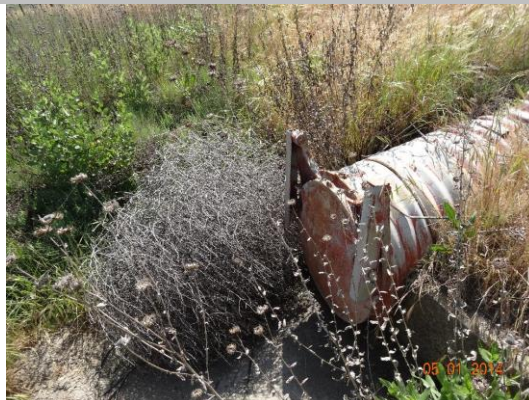
Photo 2 of 3 : UCIP_SP_2019_36506_66117.jpg

Flap gate visible on waterward side.

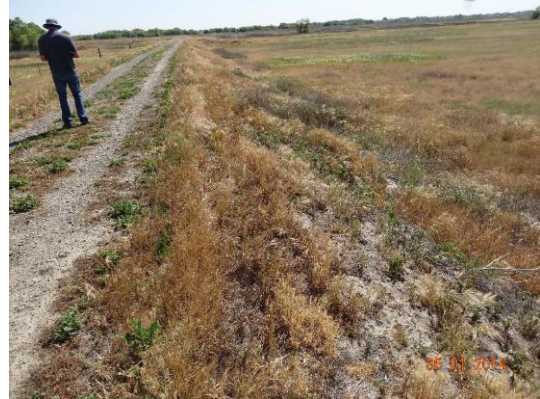
Photo 3 of 3 : UCIP_SP_2019_36506_66116.jpg

Comment Code						
Inspector Comment						
FS_ID:36506						
DS_ID:19655						
EP_NO: N/A						
Repair Type: Non-Urgent						
Crossing Status: Found						
UCIP Comments: 05/01/2014 Dense vegetation limits the inspector's visibility to identify signs of pipe failure (leaks) along the slope. Recommend removing vegetation along pipe alignment to conduct proper inspection of structure. (DWR UCIP - O. Magana)						
FIELD_STRUCT_DESC: 24-inch corrugated metal gravity drainage pipe through the levee, 8.6 feet below the crown. Flap gate on the waterside (WS) end. Brass cap No. 136 bench mark (BM) on the headwall on the landside (LS). [Additional Reference(s): DWR Levee Log, 2002. USACE San Joaquin O&M Manual 601.1, 1967, (HLM 1.22)].						
FS Date: 5/1/2014

View of landward side.

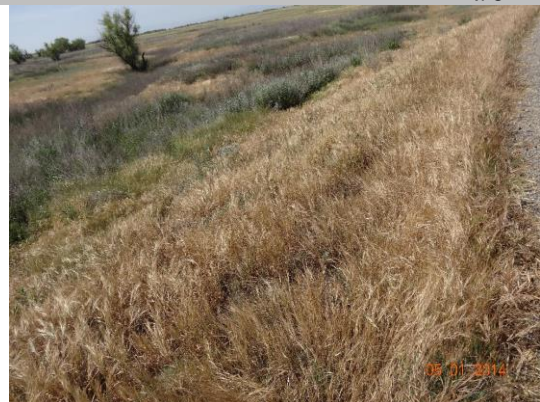
Photo 1 of 3 : UCIP_SP_2019_36507_66120.jpg

Comment Code						
Inspector Comment						
FS_ID:36507 DS_ID:19656 EP_NO: N/A Repair Type: Non-Urgent Crossing Status: Found UCIP Comments: 05/01/2014 Dense vegetation limits the inspector's visibility to identify signs of pipe failure (leaks) along the slope. Recommend removing vegetation along pipe alignment to conduct proper inspection of structure. (DWR UCIP - O. Magana) FIELD_STRUCT_DESC: 36-inch corrugated metal gravity drainage pipe through the levee, 14.6 feet below the crown. Flap gate on the waterside (WS) end. Brass cap No. 135 bench mark (BM) on the headwall on the landside (LS). [Additional Reference(s): DWR Levee Log, 2002. USACE San Joaquin O&M Manual 601.1, 1967, (HLM 1.34)]. FS Date: 5/1/2014

View of landward side.

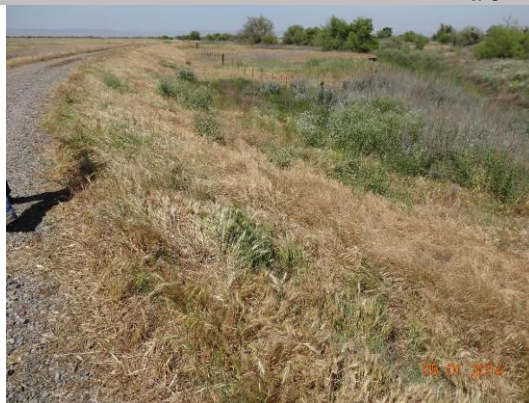
Photo 2 of 3 : UCIP_SP_2019_36507_66119.jpg

Comment Code						
Inspector Comment						
FS_ID:36507 DS_ID:19656 EP_NO: N/A Repair Type: Non-Urgent Crossing Status: Found UCIP Comments: 05/01/2014 Dense vegetation limits the inspector's visibility to identify signs of pipe failure (leaks) along the slope. Recommend removing vegetation along pipe alignment to conduct proper inspection of structure. (DWR UCIP - O. Magana) FIELD_STRUCT_DESC: 36-inch corrugated metal gravity drainage pipe through the levee, 14.6 feet below the crown. Flap gate on the waterside (WS) end. Brass cap No. 135 bench mark (BM) on the headwall on the landside (LS). [Additional Reference(s): DWR Levee Log, 2002. USACE San Joaquin O&M Manual 601.1, 1967, (HLM 1.34)]. FS Date: 5/1/2014

View of waterward side.

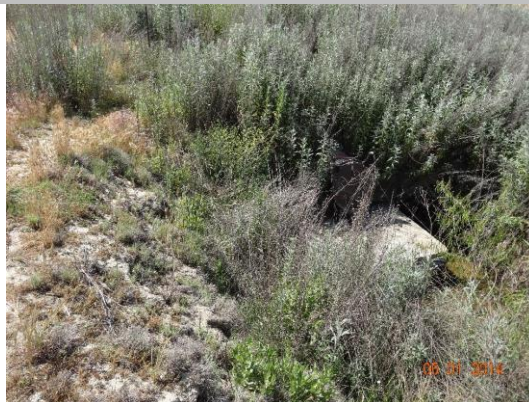
Photo 3 of 3 : UCIP_SP_2019_36507_66118.jpg

Flap gate and concrete apron visible on waterward side.

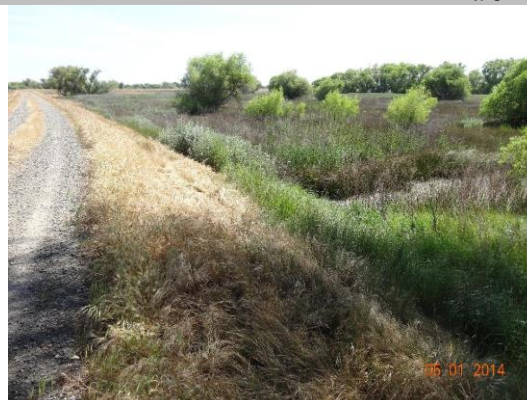
Photo 1 of 3 : UCIP_SP_2019_36508_66124.jpg

Comment Code					
Inspector Comment					
FS_ID:36508 DS_ID:19657 EP_NO: N/A Repair Type: Non-Urgent Crossing Status: Found UCIP Comments: 05/01/2014 Dense vegetation limits the inspector's visibility to identify signs of pipe failure (leaks) along the slope. Recommend removing vegetation along pipe alignment to conduct proper inspection of structure. (DWR UCIP - O. Magana) FIELD_STRUCT_DESC: 24-inch corrugated metal gravity drainage pipe through the levee, 10.2 feet below the crown. Flap gate on the waterside (WS) end. Brass cap No. 135 bench mark (BM) on the headwall on the landside (LS). [Additional Reference(s): DWR Levee Log, 2002. USACE San Joaquin O&M Manual 601.1, 1967, (HLM 1.62)]. FS Date: 5/1/2014

Overview of landward side.
