**Flood Control Project Maintenance
Levee Inspections**
LMA District Cover Sheet
Spring 2019 Levee Inspection Results

Lower San Joaquin Levee District

Spring 2019 Levee Inspection Results

Waterway			Bank	Unit Miles
Unit No. 01 San Joaquin River			Right	22.52
	Spring (March - May)	Summer (June - August)	(September - November) Fall	Winter (December - February)
Unit Maintenance Rating (Fall Only)				
Date of Inspection	3/26/2019 - 3/26/2019			
DWR Inspector	Corey Fujitani			
Accompanied By

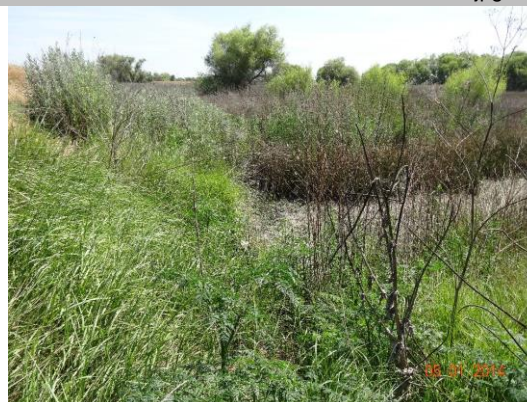
Photo 2 of 3 : UCIP_SP_2019_36508_66123.jpg

Dense vegetation along levee slope and toe.

Comment Code						
Inspector Comment						
FS_ID:36508 DS_ID:19657 EP_NO: N/A Repair Type: Non-Urgent Crossing Status: Found UCIP Comments: 05/01/2014 Dense vegetation limits the inspector's visibility to identify signs of pipe failure (leaks) along the slope. Recommend removing vegetation along pipe alignment to conduct proper inspection of structure. (DWR UCIP - O. Magana) FIELD_STRUCT_DESC: 24-inch corrugated metal gravity drainage pipe through the levee, 10.2 feet below the crown. Flap gate on the waterside (WS) end. Brass cap No. 135 bench mark (BM) on the headwall on the landside (LS). [Additional Reference(s): DWR Levee Log, 2002. USACE San Joaquin O&M Manual 601.1, 1967, (HLM 1.62)]. FS Date: 5/1/2014

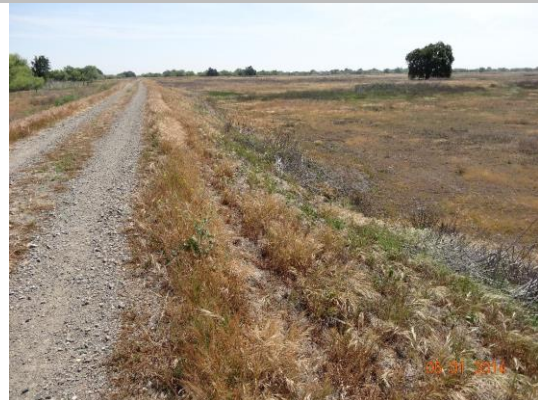
Photo 1 of 3 : UCIP_SP_2019_36509_66129.jpg

Comment Code					
Inspector Comment					
FS_ID:36509 DS_ID:19658 EP_NO: N/A Repair Type: Non-Urgent Crossing Status: Found UCIP Comments: 05/01/2014 Dense vegetation limits the inspector's visibility to identify signs of pipe failure (leaks) along the slope. Recommend removing vegetation along pipe alignment to conduct proper inspection of structure. (DWR UCIP - O. Magana) FIELD_STRUCT_DESC: 24-inch corrugated metal gravity drainage pipe through the levee, 10.7 feet below the crown. Flap gate on the waterside (WS) end. Brass cap No. 135 bench mark (BM) on the headwall on the landside (LS). [Additional Reference(s): DWR Levee Log, 2002. USACE San Joaquin O&M Manual 601.1, 1967, (HLM 1.86)]. FS Date: 5/1/2014

View of landward side.

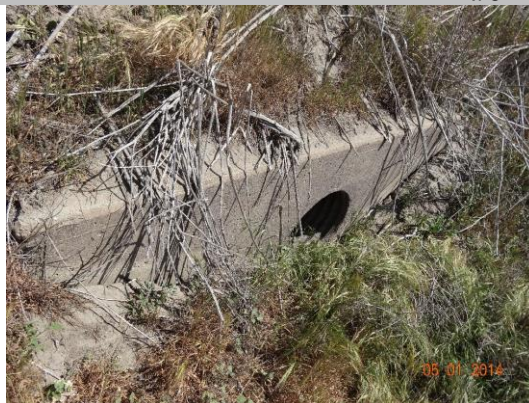
Photo 2 of 3 : UCIP_SP_2019_36509_66128.jpg

Comment Code						
Inspector Comment						
FS_ID:36509						
DS_ID:19658						
EP_NO: N/A						
Repair Type: Non-Urgent						
Crossing Status: Found						
UCIP Comments: 05/01/2014 Dense vegetation limits the inspector's visibility to identify signs of pipe failure (leaks) along the slope. Recommend removing vegetation along pipe alignment to conduct proper inspection of structure. (DWR UCIP - O. Magana)						
FIELD_STRUCT_DESC: 24-inch corrugated metal gravity drainage pipe through the levee, 10.7 feet below the crown. Flap gate on the waterside (WS) end. Brass cap No. 135 bench mark (BM) on the headwall on the landside (LS). [Additional Reference(s): DWR Levee Log, 2002. USACE San Joaquin O&M Manual 601.1, 1967, (HLM 1.86)].						
FS Date: 5/1/2014

Concrete headwall visible on landward side.

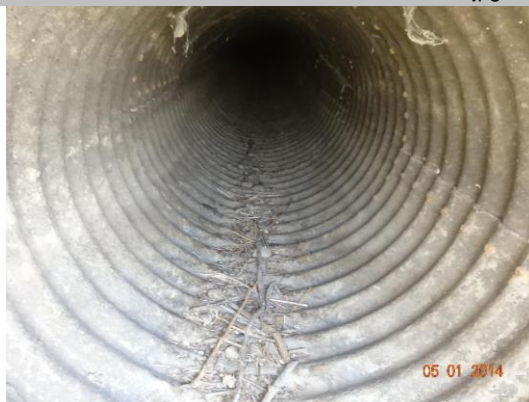
Photo 3 of 3 : UCIP_SP_2019_36509_66127.jpg

Inside view of pipe from landward side.

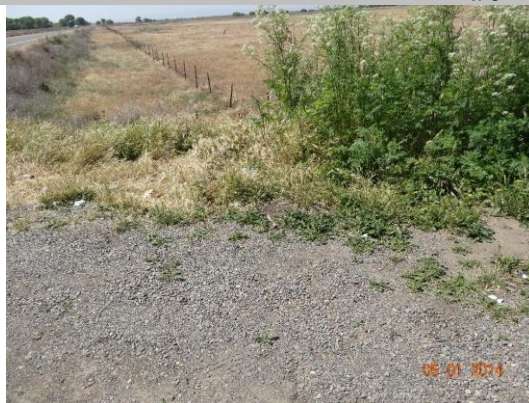
Photo 1 of 3 : UCIP_SP_2019_36510_66133.jpg

Comment Code					
Inspector Comment					
FS_ID:36510 DS_ID:19659 EP_NO: N/A Repair Type: Non-Urgent Crossing Status: Found UCIP Comments: 05/01/2014 Dense vegetation limits the inspector's visibility to identify signs of pipe failure (leaks) along the slope. Recommend removing vegetation along pipe alignment to conduct proper inspection of structure. (DWR UCIP - O. Magana) FIELD_STRUCT_DESC: 24-inch corrugated metal gravity drainage pipe through the levee, 7 feet below the crown. Flap gate on the waterside (WS) end. Brass cap No. 135 bench mark (BM) on the headwall on the landside (LS). [Additional Reference(s): DWR Levee Log, 2002. USACE San Joaquin O&M Manual 601.1, 1967, (HLM 2.30)]. FS Date: 5/1/2014

View of landward side.

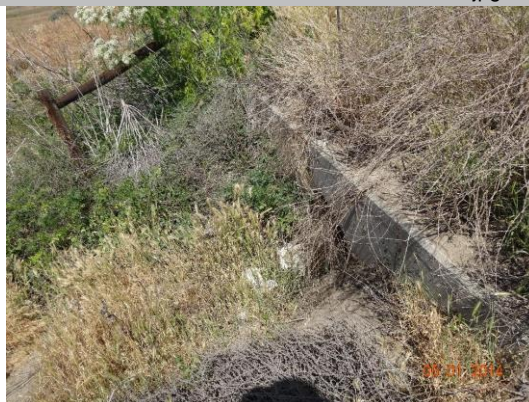
Photo 2 of 3 : UCIP_SP_2019_36510_66132.jpg

Concrete headwall visible on landward side.

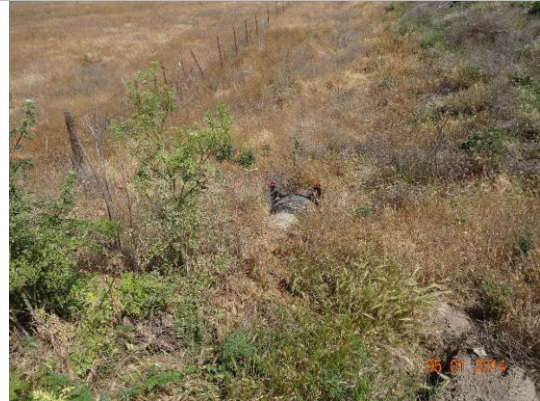
Photo 3 of 3 : UCIP_SP_2019_36510_66131.jpg

Comment Code						
Inspector Comment						
FS_ID:36510 DS_ID:19659 EP_NO: N/A Repair Type: Non-Urgent Crossing Status: Found UCIP Comments: 05/01/2014 Dense vegetation limits the inspector's visibility to identify signs of pipe failure (leaks) along the slope. Recommend removing vegetation along pipe alignment to conduct proper inspection of structure. (DWR UCIP - O. Magana) FIELD_STRUCT_DESC: 24-inch corrugated metal gravity drainage pipe through the levee, 7 feet below the crown. Flap gate on the waterside (WS) end. Brass cap No. 135 bench mark (BM) on the headwall on the landside (LS). [Additional Reference(s): DWR Levee Log, 2002. USACE San Joaquin O&M Manual 601.1, 1967, (HLM 2.30)]. FS Date: 5/1/2014

View of pipe through levee visible on waterward side.

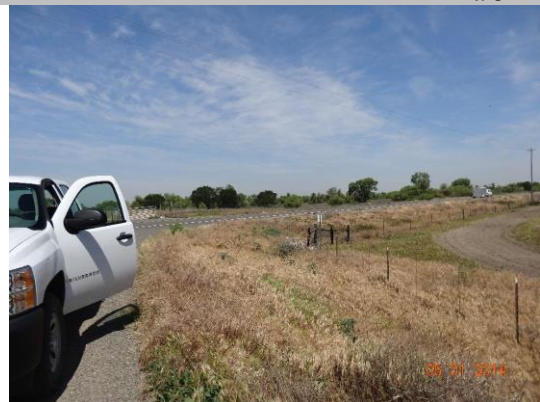
Photo 1 of 3 : UCIP_SP_2019_36511_66137.jpg

Comment Code					
Inspector Comment					
FS_ID:36511					
DS_ID:19660					
EP_NO: N/A					
Repair Type: Non-Urgent					
Crossing Status: Found					
UCIP Comments: 05/01/2014 Dense vegetation limits the inspector's visibility to identify signs of pipe failure (leaks) along the slope. Recommend removing vegetation along pipe alignment to conduct proper inspection of structure. (DWR UCIP - O. Magana)					
FIELD_STRUCT_DESC: 24-inch corrugated metal gravity drainage pipe through the levee, 7 feet below the crown. Flap gate on the waterside (WS) end. Brass cap No. 135 bench mark (BM) on the headwall on the landside (LS). [Additional Reference(s): DWR Levee Log, 2002. USACE San Joaquin O&M Manual 601.1, 1967, (HLM 2.32)].					
FS Date: 5/1/2014

View of waterward side.

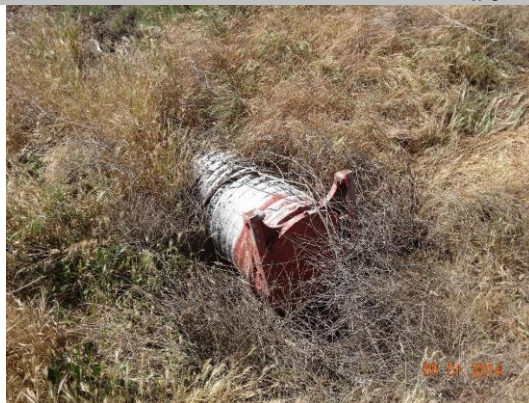
Photo 2 of 3 : UCIP_SP_2019_36511_66136.jpg

Comment Code						
Inspector Comment						
FS_ID:36511 DS_ID:19660 EP_NO: N/A Repair Type: Non-Urgent Crossing Status: Found UCIP Comments: 05/01/2014 Dense vegetation limits the inspector's visibility to identify signs of pipe failure (leaks) along the slope. Recommend removing vegetation along pipe alignment to conduct proper inspection of structure. (DWR UCIP - O. Magana) FIELD_STRUCT_DESC: 24-inch corrugated metal gravity drainage pipe through the levee, 7 feet below the crown. Flap gate on the waterside (WS) end. Brass cap No. 135 bench mark (BM) on the headwall on the landside (LS). [Additional Reference(s): DWR Levee Log, 2002. USACE San Joaquin O&M Manual 601.1, 1967, (HLM 2.32)]. FS Date: 5/1/2014

Flap gate visible on waterward side.

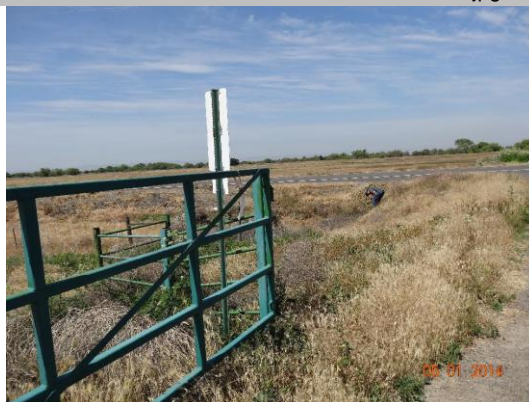
Photo 3 of 3 : UCIP_SP_2019_36511_66138.jpg

Overview of landward slope.

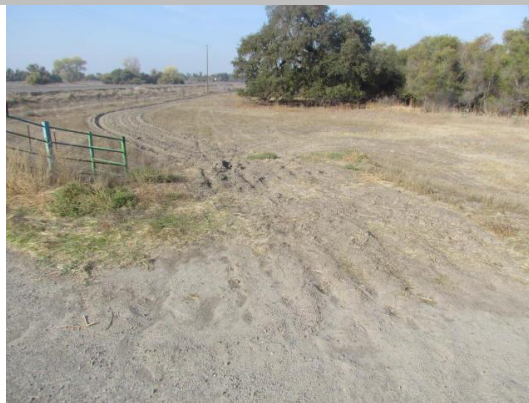
Photo 1 of 4 : SP_2019_NA0010_119_2_20190307_00001.jpg

Looking northeast at unauthorized ramp on landward slope.

LM Start	2.32	Rating **	M	Issue No.	2 (cont)	
LM End	2.32	Issue Type +	En	Location *	LS	
Category	Earthen Levee			GPS Latitude/Longitude		
				Start		End
Item	Encroachments			37.291433 °		37.291433 °
				-120.850917 °		-120.850917 °
DWR ID	DWR_NA0010_02A_s_2012_2					
Comment Code						
RA : Ramp						
Inspector Comment						
Unauthorized ramps are located on the landside and waterside slopes.

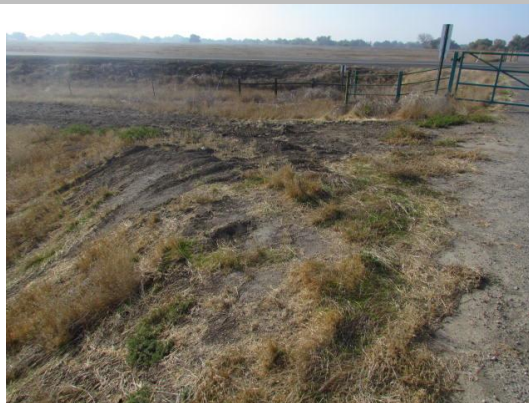
Photo 3 of 4 : SP_2019_NA0010_119_2_20190307_00003.jpg

Looking northwest at unauthorized ramp on waterward slope.

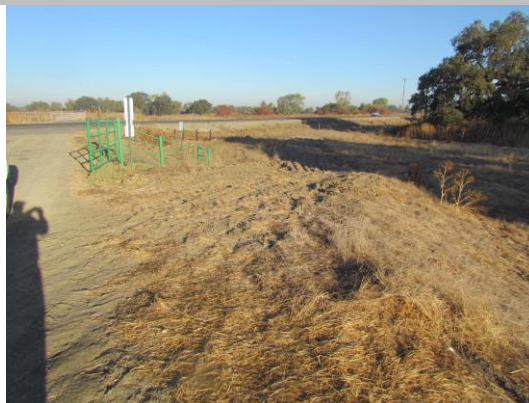
Photo 4 of 4 : SP_2019_NA0010_119_2_20190307_00004.jpg

Looking at ramp on landward slope. (Fall 2016)

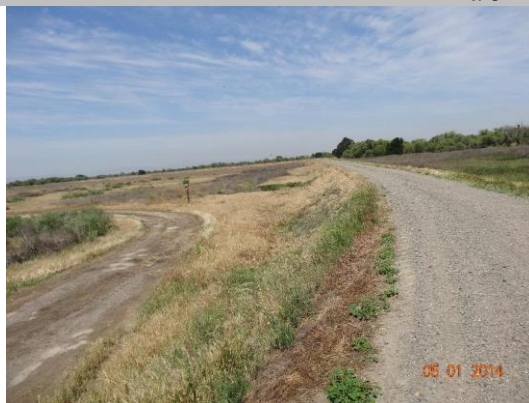
Photo 1 of 3 : UCIP_SP_2019_36512_66142.jpg

Comment Code					
Inspector Comment					
FS_ID:36512 DS_ID:19661 EP_NO: N/A Repair Type: Non-Urgent Crossing Status: Found UCIP Comments: 05/01/2014 Dense vegetation limits the inspector's visibility to identify signs of pipe failure (leaks) along the slope. Recommend removing vegetation along pipe alignment to conduct proper inspection of structure. (DWR UCIP - O. Magana) FIELD_STRUCT_DESC: 24-inch corrugated metal gravity drainage pipe through the levee, 10 feet below the crown. Flap gate on the waterside (WS) end. Brass cap No. 130 bench mark (BM) on the headwall on the landside (LS). [Additional Reference(s): DWR Levee Log, 2002. USACE San Joaquin O&M Manual 601.1, 1967, (HLM 2.59)]. FS Date: 5/1/2014

View of landward side.

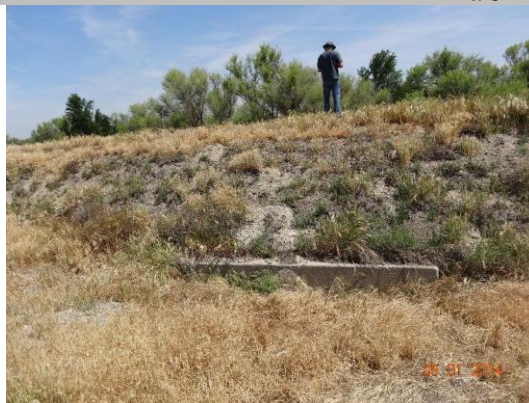
Photo 2 of 3 : UCIP_SP_2019_36512_66141.jpg

Comment Code						
Inspector Comment						
FS_ID:36512						
DS_ID:19661						
EP_NO: N/A						
Repair Type: Non-Urgent						
Crossing Status: Found						
UCIP Comments: 05/01/2014 Dense vegetation limits the inspector's visibility to identify signs of pipe failure (leaks) along the slope. Recommend removing vegetation along pipe alignment to conduct proper inspection of structure. (DWR UCIP - O. Magana)						
FIELD_STRUCT_DESC: 24-inch corrugated metal gravity drainage pipe through the levee, 10 feet below the crown. Flap gate on the waterside (WS) end. Brass cap No. 130 bench mark (BM) on the headwall on the landside (LS). [Additional Reference(s): DWR Levee Log, 2002. USACE San Joaquin O&M Manual 601.1, 1967, (HLM 2.59)].						
FS Date: 5/1/2014

Concrete headwall visible on landward side.

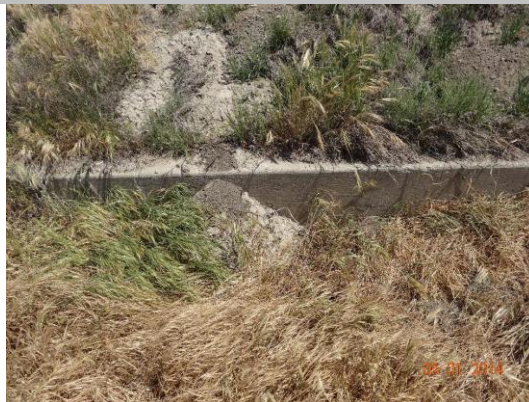
Photo 3 of 3 : UCIP_SP_2019_36512_66140.jpg

Non-functional crossing concrete headwall and inlet buried on landward side.

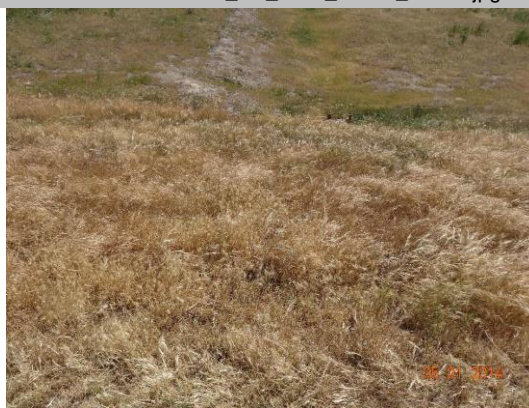
Photo 1 of 3 : UCIP_SP_2019_36513_66145.jpg

View of waterward side.

Comment Code						
Inspector Comment						
FS_ID:36513 DS_ID:19662 EP_NO: N/A Repair Type: Non-Urgent Crossing Status: Found UCIP Comments: 05/01/2014 Dense vegetation limits the inspector's visibility to identify signs of pipe failure (leaks) along the slope. Recommend removing vegetation along pipe alignment to conduct proper inspection of structure. (DWR UCIP - O. Magana) FIELD_STRUCT_DESC: 24-inch corrugated metal gravity drainage pipe through the levee, 10 feet below the crown. Flap gate on the waterside (WS) end. Brass cap No. 130 bench mark (BM) on the headwall on the landside (LS). [Additional Reference(s): DWR Levee Log, 2002. USACE San Joaquin O&M Manual 601.1, 1967, (HLM 2.96)]. FS Date: 5/1/2014

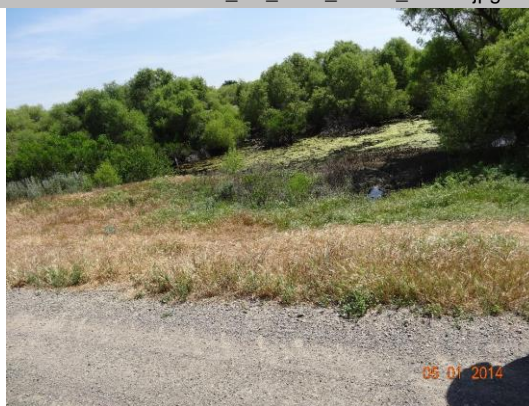
Photo 1 of 3 : UCIP_SP_2019_36514_66151.jpg

Comment Code						
Inspector Comment						
FS_ID:36514 DS_ID:19665 EP_NO: N/A Repair Type: Non-Urgent Crossing Status: Found UCIP Comments: 05/01/2014 Dense vegetation limits the inspector's visibility to identify signs of pipe failure (leaks) along the slope. Recommend removing vegetation along pipe alignment to conduct proper inspection of structure. (DWR UCIP - O. Magana) FIELD_STRUCT_DESC: 24-inch corrugated metal gravity drainage pipe through the levee, 12.4 feet below the crown. Flap gate on the waterside (WS) end. Brass cap No. 130 bench mark (BM) on the headwall on the landside (LS). [Additional Reference(s): DWR Levee Log, 2002. USACE San Joaquin O&M Manual 601.1, 1967, (HLM 3.29)]. FS Date: 5/1/2014

View of waterward side.

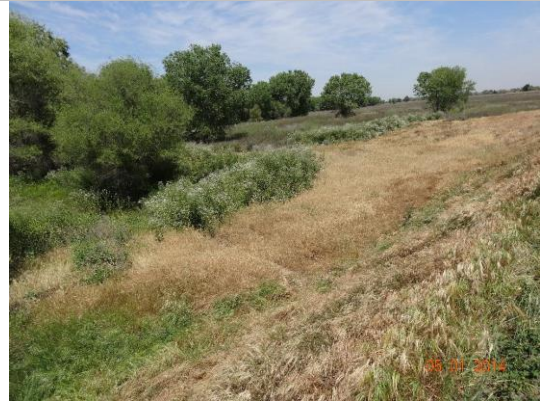
Photo 3 of 3 : UCIP_SP_2019_36514_66152.jpg

View of landward side.

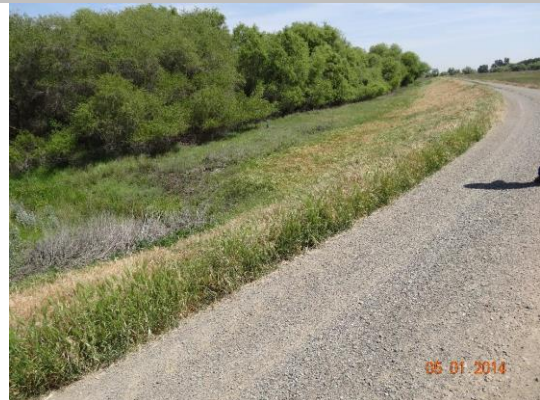
Photo 1 of 3 : UCIP_SP_2019_36515_66155.jpg

Comment Code						
Inspector Comment						
FS_ID:36515						
DS_ID:19666						
EP_NO: N/A						
Repair Type: Non-Urgent						
Crossing Status: Found						
UCIP Comments: 05/01/2014 Dense vegetation limits the inspector's visibility to identify signs of pipe failure (leaks) along the slope. Recommend removing vegetation along pipe alignment to conduct proper inspection of structure. (DWR UCIP - O. Magana)						
FIELD_STRUCT_DESC: 24-inch corrugated metal gravity drainage pipe through the levee, 10 feet below the crown. Flap gate on the waterside (WS) end. Brass cap No. 130 bench mark (BM) on the headwall on the landside (LS). [Additional Reference(s): DWR Levee Log, 2002. USACE San Joaquin O&M Manual 601.1, 1967, (HLM 3.62)].						
FS Date: 5/1/2014

View of waterward side.

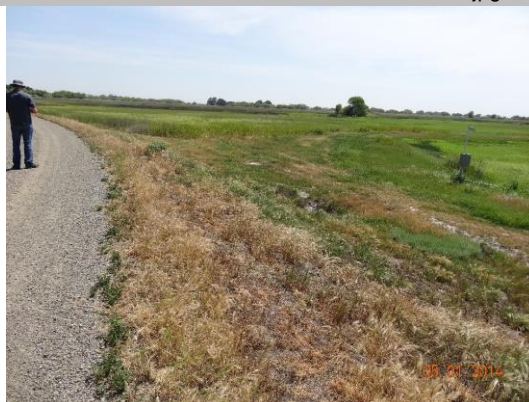
Photo 3 of 3 : UCIP_SP_2019_36515_66156.jpg

Comment Code						
Inspector Comment						
FS_ID:36515 DS_ID:19666 EP_NO: N/A Repair Type: Non-Urgent Crossing Status: Found UCIP Comments: 05/01/2014 Dense vegetation limits the inspector's visibility to identify signs of pipe failure (leaks) along the slope. Recommend removing vegetation along pipe alignment to conduct proper inspection of structure. (DWR UCIP - O. Magana) FIELD_STRUCT_DESC: 24-inch corrugated metal gravity drainage pipe through the levee, 10 feet below the crown. Flap gate on the waterside (WS) end. Brass cap No. 130 bench mark (BM) on the headwall on the landside (LS). [Additional Reference(s): DWR Levee Log, 2002. USACE San Joaquin O&M Manual 601.1, 1967, (HLM 3.62)]. FS Date: 5/1/2014

View of landward side.

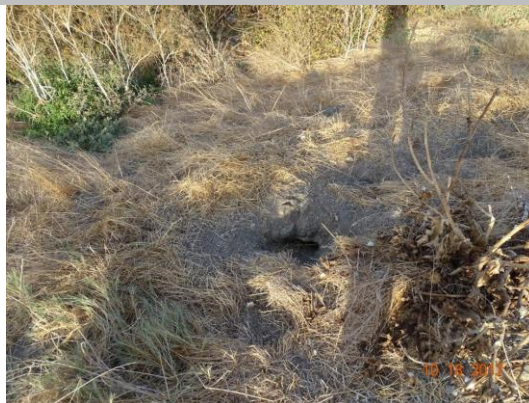
Photo 1 of 1 : SP_2019_NA0010_119_28_20190307_00015.jpg

LM Start	6.97	Rating **	M	Issue No.	28
LM End	6.97	Issue Type +	Ma	Location *	LS
Category	Earthen Levee			GPS Latitude/Longitude	
				Start	End
Item	Animal Control			37.241125 °	37.241125 °
				-120.821747 °	-120.821747 °
DWR ID	DWR_NA0010_02A_f_2017_28				
Comment Code					
A3 : No rodents visible, but rodent burrows visible; need to backfill and compact or grout burrows.					
Inspector Comment

Looking northwest at landside slope.

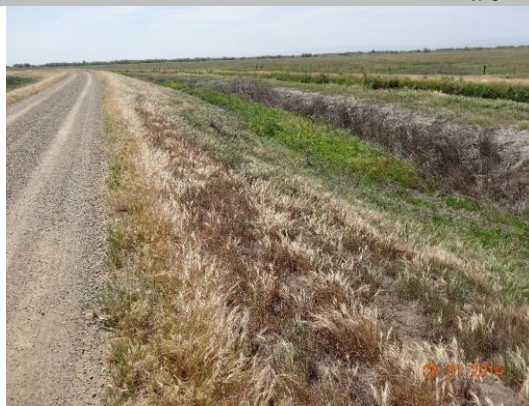
Photo 1 of 3 : UCIP_SP_2019_39365_66178.jpg

Comment Code						
Inspector Comment						
FS_ID:39365 DS_ID:19671 EP_NO: N/A Repair Type: Non-Urgent Crossing Status: Found UCIP Comments: 05/01/2014 Dense vegetation limits the inspector's visibility to identify signs of pipe failure (leaks) along the slope. Recommend removing vegetation along pipe alignment to conduct proper inspection of structure. Pipe extension visible on landward side-- need to contact owner for additional information about extension/modification. (DWR UCIP - O. Magana) FIELD_STRUCT_DESC: 24-inch corrugated metal gravity drainage pipe through the levee, 12.6 feet below the crown. Flap gate on the waterside (WS) end. Brass cap No. 125 bench mark (BM) on the headwall on the landside (LS). [Additional Reference(s): DWR Levee Log, 2002. USACE San Joaquin O&M Manual 601.1, 1967, (HLM 7.05)]. FS Date: 5/1/2014

View of landward side.

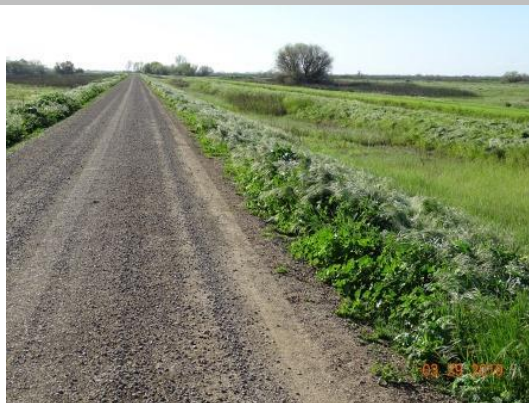
Photo 1 of 1 : SP_2019_NA0010_120_18_20190415_00050.jpg

LM Start	7.87	Rating **	U	Issue No.	18
LM End	13.72	Issue Type +	Ma	Location *	LS
Category	Earthen Levee			GPS Latitude/Longitude	
				Start	End
Item	Vegetation			37.231266 °	37.172587 °
				-120.811850 °	-120.761157 °
DWR ID	DWR_NA0010_02B_s_2019_18				
Comment Code					
V1 : Control annual grass and weeds on the levee slopes and easements.					
Inspector Comment

View of landside slope looking upstream. (Spring 2019)

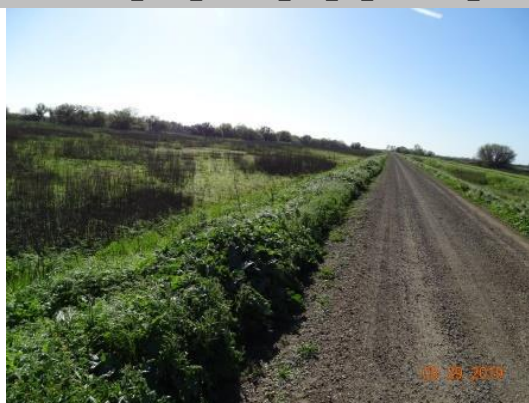
Photo 1 of 1 : SP_2019_NA0010_120_23_20190415_00051.jpg

LM Start	7.87	Rating **	U	Issue No.	23
LM End	13.72	Issue Type +	Ma	Location *	WS
Category	Earthen Levee			GPS Latitude/Longitude	
				Start	End
Item	Vegetation			37.231266 °	37.172587 °
				-120.811850 °	-120.761157 °
DWR ID	DWR_NA0010_02B_s_2019_23				
Comment Code					
V1 : Control annual grass and weeds on the levee slopes and easements.					
Inspector Comment

View of waterside slope looking upstream. (Spring 2019)

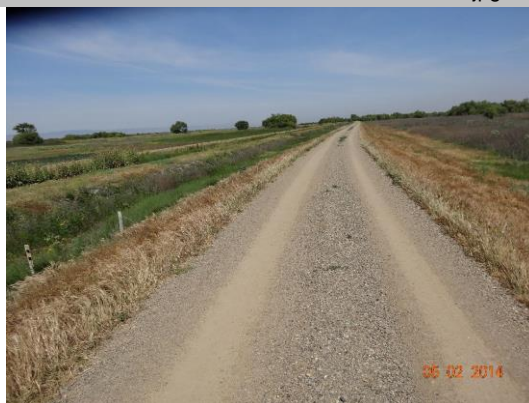
Photo 2 of 3 : UCIP_SP_2019_39366_66185.jpg

Comment Code					
Inspector Comment					
FS_ID:39366 DS_ID:19674 EP_NO: N/A Repair Type: Non-Urgent Crossing Status: Found UCIP Comments: 05/14/2014 Dense vegetation limits the inspector's visibility to identify signs of pipe failure (leaks) along the slope and landward headwall. Recommend removing vegetation along pipe alignment and toe to conduct proper inspection of structure. Sediment buildup in pipe visible from landward side--recommend clearing. (DWR UCIP - O. Magana) FIELD_STRUCT_DESC: 24-inch corrugated metal gravity drainage pipe through the levee, 9 feet below the crown. Flap gate on the waterside (WS) end. Brass cap No. 120 bench mark (BM) on the headwall on the landside (LS). [Additional Reference(s): DWR Levee Log, 2002. USACE San Joaquin O&M Manual 601.1, 1967, (HLM 8.16)]. FS Date: 5/14/2014

Overview of levee crown at crossing.

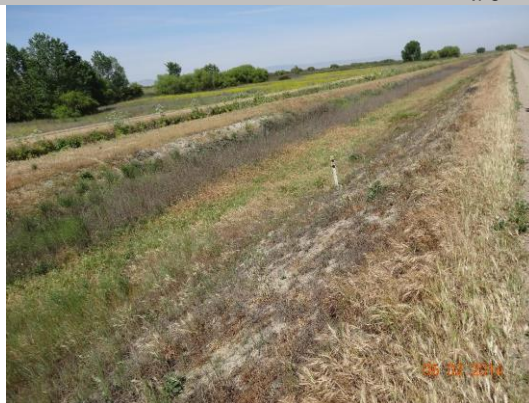
Photo 1 of 3 : UCIP_SP_2019_39367_66195.jpg

Comment Code						
Inspector Comment						
FS_ID:39367 DS_ID:19675 EP_NO: N/A Repair Type: Non-Urgent Crossing Status: Found UCIP Comments: 05/14/2014 Dense vegetation on landward toe. Also dense vegetation limits the inspector's visibility to identify signs of pipe failure (leaks) along waterward slope. Recommend removing vegetation along pipe alignment toe to conduct proper inspection of structure. Sediment buildup in pipe--recommend clearing. (DWR UCIP - O. Magana) FIELD_STRUCT_DESC: 24-inch corrugated metal gravity drainage pipe through the levee, 9.4 feet below the crown. Flap gate on the waterside (WS) end. Brass cap No. 120 bench mark (BM) on the headwall on the landside (LS). [Additional Reference(s): DWR Levee Log, 2002. USACE San Joaquin O&M Manual 601.1, 1967, (HLM 8.48)]. FS Date: 5/14/2014

View of landward side.

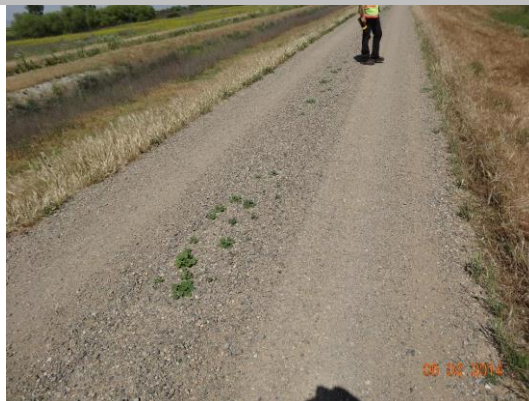
Photo 2 of 3 : UCIP_SP_2019_39367_66193.jpg

Overview of levee crown at crossing.

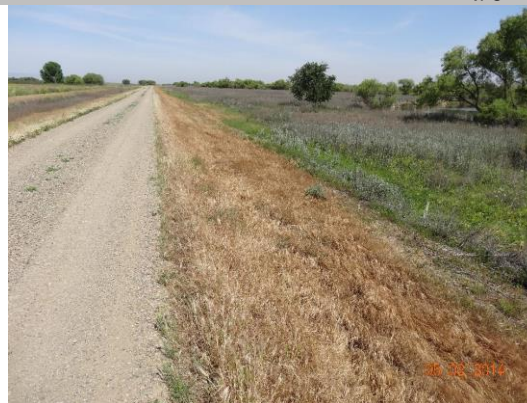
Photo 3 of 3 : UCIP_SP_2019_39367_66194.jpg

Comment Code						
Inspector Comment						
FS_ID:39367						
DS_ID:19675						
EP_NO: N/A						
Repair Type: Non-Urgent						
Crossing Status: Found						
UCIP Comments: 05/14/2014 Dense vegetation on landward toe. Also dense vegetation limits the inspector's visibility to identify signs of pipe failure (leaks) along waterward slope. Recommend removing vegetation along pipe alignment toe to conduct proper inspection of structure. Sediment buildup in pipe--recommend clearing. (DWR UCIP - O. Magana)						
FIELD_STRUCT_DESC: 24-inch corrugated metal gravity drainage pipe through the levee, 9.4 feet below the crown. Flap gate on the waterside (WS) end. Brass cap No. 120 bench mark (BM) on the headwall on the landside (LS). [Additional Reference(s): DWR Levee Log, 2002. USACE San Joaquin O&M Manual 601.1, 1967, (HLM 8.48)].						
FS Date: 5/14/2014

View of waterward side.

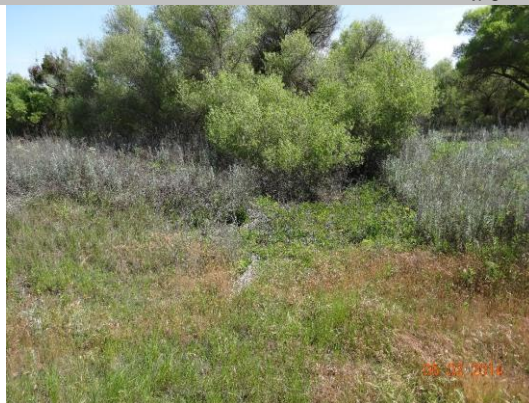
Photo 3 of 3 : UCIP_SP_2019_42503_66201.jpg

Comment Code						
Inspector Comment						
FS_ID:42503 DS_ID:19676 EP_NO: N/A Repair Type: Non-Urgent Crossing Status: Found UCIP Comments: 05/14/2014 Dense vegetation limits the inspector's visibility to identify signs of pipe failure (leaks) along the slope. Recommend removing vegetation along pipe alignment to conduct proper inspection of structure. Burrow activity presen on waterward slope. (DWR UCIP - O. Magana) FIELD_STRUCT_DESC: 24-inch corrugated metal gravity drainage pipe through the levee, 8.8 feet below the crown. Flap gate on the waterside (WS) end. Brass cap No. 120 bench mark (BM) on the headwall on the landside (LS). [Additional Reference(s): DWR Levee Log, 2002. USACE San Joaquin O&M Manual 601.1, 1967, (recorded as HLM 9.86 should be 8.86)]. FS Date: 5/14/2014

View of waterward toe.

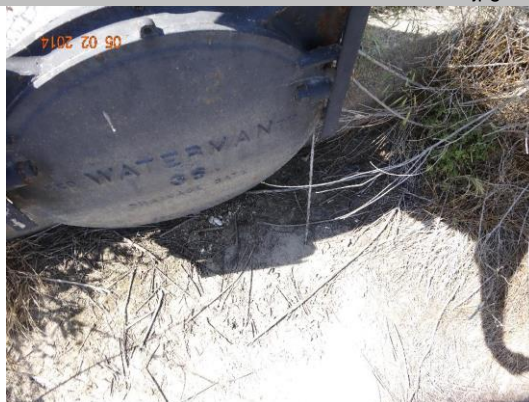
Photo 2 of 3 : UCIP_SP_2019_36525_66207.jpg

Comment Code					
Inspector Comment					
FS_ID:36525 DS_ID:19677 EP_NO: N/A Repair Type: Non-Urgent Crossing Status: Found UCIP Comments: 05/14/2014 Dense vegetation limits the inspector's visibility to identify signs of pipe failure (leaks) along the slope. Recommend removing vegetation along pipe alignment to conduct proper inspection of structure. (DWR UCIP - O. Magana) FIELD_STRUCT_DESC: 36-inch corrugated metal gravity drainage pipe through the levee, 8.8 feet below the crown. Flap gate on the waterside (WS) end. Brass cap No. 120 bench mark (BM) on the headwall on the landside (LS). [Additional Reference(s): DWR Levee Log, 2002. USACE San Joaquin O&M Manual 601.1, 1967, (HLM 9.02)]. FS Date: 5/14/2014

View of flap gate visible from waterward side.

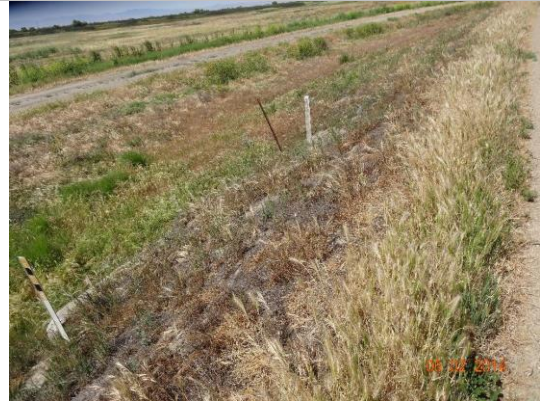
Photo 3 of 3 : UCIP_SP_2019_36525_66206.jpg

Comment Code						
Inspector Comment						
FS_ID:36525 DS_ID:19677 EP_NO: N/A Repair Type: Non-Urgent Crossing Status: Found UCIP Comments: 05/14/2014 Dense vegetation limits the inspector's visibility to identify signs of pipe failure (leaks) along the slope. Recommend removing vegetation along pipe alignment to conduct proper inspection of structure. (DWR UCIP - O. Magana) FIELD_STRUCT_DESC: 36-inch corrugated metal gravity drainage pipe through the levee, 8.8 feet below the crown. Flap gate on the waterside (WS) end. Brass cap No. 120 bench mark (BM) on the headwall on the landside (LS). [Additional Reference(s): DWR Levee Log, 2002. USACE San Joaquin O&M Manual 601.1, 1967, (HLM 9.02)]. FS Date: 5/14/2014

View of landward side.

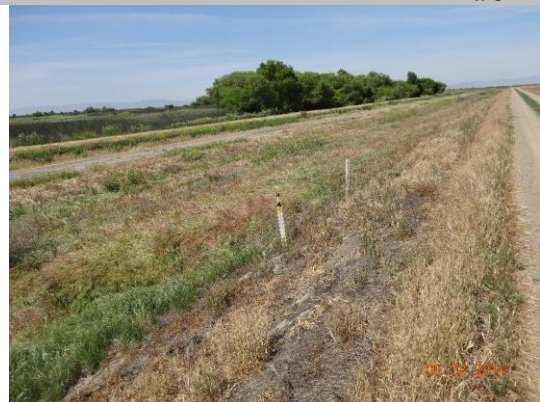
Photo 1 of 3 : UCIP_SP_2019_40443_66211.jpg

Comment Code						
Inspector Comment						
FS_ID:40443 DS_ID:19678 EP_NO: N/A Repair Type: Non-Urgent Crossing Status: Found UCIP Comments: 05/14/2014 Dense vegetation limits the inspector's visibility to identify signs of pipe failure (leaks) along the slope. Recommend removing vegetation along pipe alignment to conduct proper inspection of structure. (DWR UCIP - O. Magana) FIELD_STRUCT_DESC: 24-inch corrugated metal gravity drainage pipe through the levee, 8 feet below the crown. Flap gate on the waterside (WS) end. Brass cap No. 120 bench mark (BM) on the headwall on the landside (LS). [Additional Reference(s): DWR Levee Log, 2002. USACE San Joaquin O&M Manual 601.1, 1967, (HLM 9.20)]. FS Date: 5/14/2014

View of landward side.

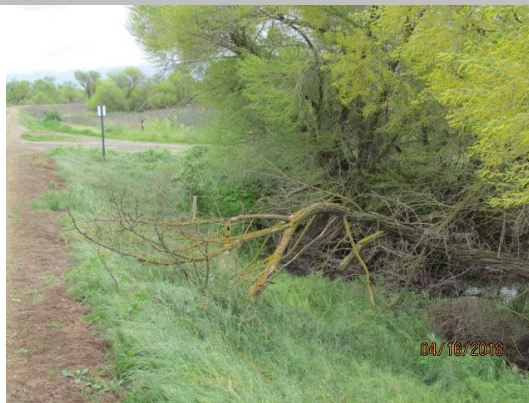
Photo 1 of 2 : SP_2019_NA0010_120_17_20190307_00006.jpg

LM Start	9.42	Rating **	M	Issue No.	17
LM End	9.42	Issue Type +	Ma	Location *	LS
Category	Earthen Levee			GPS Latitude/Longitude	
				Start	End
Item	Trim / Thin Trees			37.220199°	37.220199°
				-120.788748°	-120.788748°
DWR ID	DWR_NA0010_02B_f_2016_17				
Comment Code					
T3 : Trim and thin trees to allow visibility of the ground and room to flood fight.					
Inspector Comment					
Trim back dead tree limbs on landside toe.

Looking north at broken tree limbs and branches on landward slope.
(Spring 2018)

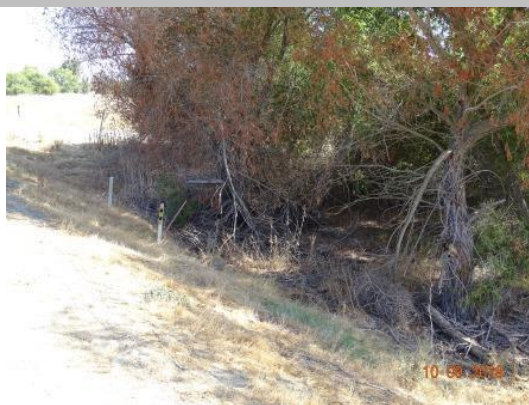
Photo 2 of 2 : SP_2019_NA0010_120_17_20190307_00007.jpg

View of dead branches on landside toe. (Fall 2018)

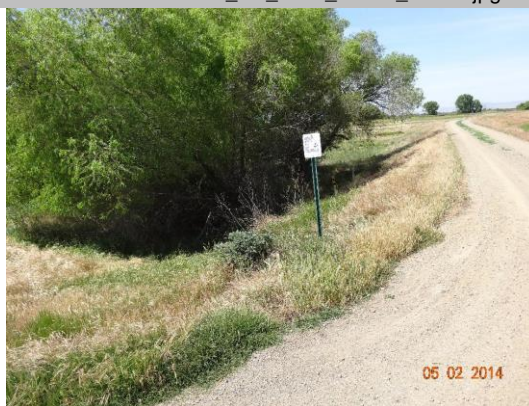
Photo 1 of 3 : UCIP_SP_2019_36527_66217.jpg

Comment Code					
Inspector Comment					
FS_ID:36527 DS_ID:19686 EP_NO: N/A Repair Type: Non-Urgent Crossing Status: Found UCIP Comments: 05/14/2014 Dense vegetation limits the inspector's visibility to identify signs of pipe failure (leaks) along the slope. Recommend removing vegetation along pipe alignment to conduct proper inspection of structure. (DWR UCIP - O. Magana) FIELD_STRUCT_DESC: 24-inch corrugated metal gravity drainage pipe through the levee, 9 feet below the crown. Flap gate on the waterside (WS) end. Brass cap No. 115 bench mark (BM) on the headwall on the landside (LS). [Additional Reference(s): DWR Levee Log, 2002. USACE San Joaquin O&M Manual 601.1, 1967, (HLM 9.46)]. FS Date: 5/14/2014

View of landward side.

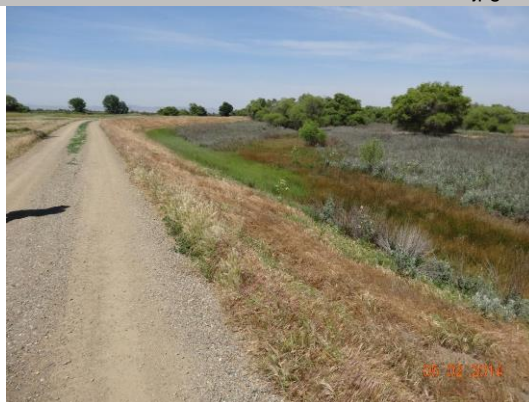
Photo 2 of 3 : UCIP_SP_2019_36527_66216.jpg

View of waterward side.

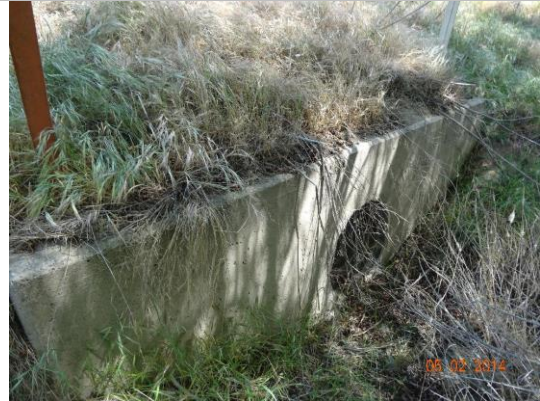
Photo 3 of 3 : UCIP_SP_2019_36527_66215.jpg

Comment Code						
Inspector Comment						
FS_ID:36527						
DS_ID:19686						
EP_NO: N/A						
Repair Type: Non-Urgent						
Crossing Status: Found						
UCIP Comments: 05/14/2014 Dense vegetation limits the inspector's visibility to identify signs of pipe failure (leaks) along the slope. Recommend removing vegetation along pipe alignment to conduct proper inspection of structure. (DWR UCIP - O. Magana)						
FIELD_STRUCT_DESC: 24-inch corrugated metal gravity drainage pipe through the levee, 9 feet below the crown. Flap gate on the waterside (WS) end. Brass cap No. 115 bench mark (BM) on the headwall on the landside (LS). [Additional Reference(s): DWR Levee Log, 2002. USACE San Joaquin O&M Manual 601.1, 1967, (HLM 9.46)].						
FS Date: 5/14/2014

Concrete headwall visible on landward side.

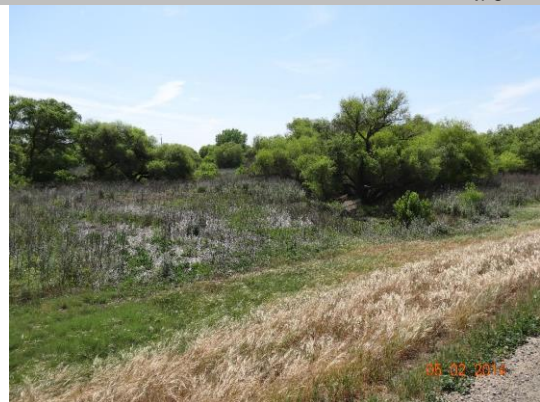
Photo 1 of 3 : UCIP_SP_2019_36528_66224.jpg

Comment Code					
Inspector Comment					
FS_ID:36528 DS_ID:19687 EP_NO: N/A Repair Type: Non-Urgent Crossing Status: Found UCIP Comments: 05/14/2014 Dense vegetation limits the inspector's visibility to identify signs of pipe failure (leaks) along the slope. Recommend removing vegetation along pipe alignment to conduct proper inspection of structure. (DWR UCIP - O. Magana) FIELD_STRUCT_DESC: 24-inch corrugated metal gravity drainage pipe through the levee, 11.7 feet below the crown. Flap gate on the waterside (WS) end. Brass cap No. 115 bench mark (BM) on the headwall on the landside (LS). [Additional Reference(s): DWR Levee Log, 2002. USACE San Joaquin O&M Manual 601.1, 1967, (HLM 10.12)]. FS Date: 5/14/2014

Overview of waterward side.

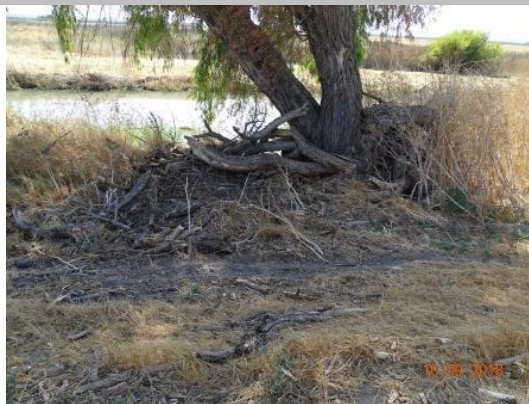
Photo 1 of 2 : SP_2019_NA0010_120_14_20190307_00004.jpg

LM Start	10.94	Rating **	M	Issue No.	14
LM End	10.94	Issue Type +	Ma	Location *	LS
Category	Earthen Levee			GPS Latitude/Longitude	
				Start	End
Item	Encroachments			37.205711 °	37.205711 °
				-120.774741 °	-120.774741 °
DWR ID	DWR_NA0010_02B_f_2015_14				
Comment Code					
PR : Prunings					
Inspector Comment					
Remove prunings from landside toe.

Prunings at landside toe. (Fall 2018)

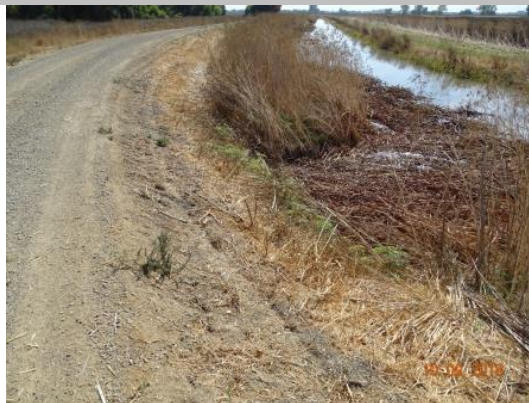
Photo 1 of 2 : SP_2019_NA0010_120_21_20190307_00011.jpg

LM Start	11.39	Rating **	U	Issue No.	21
LM End	11.39	Issue Type +	Ma	Location *	LS
Category	Earthen Levee			GPS Latitude/Longitude	
				Start	End
Item	Erosion / Bank Caving			37.201839 °	37.201839 °
				-120.768489 °	-120.768489 °
DWR ID	DWR_NA0010_02B_f_2018_21				
Comment Code					
E2 : Schedule repair of erosion site prior to the next inspection.					
Inspector Comment					
Erosion occurring into the landside slope of levee.

Erosion into landside slope. Looking upstream. (Fall 2018)

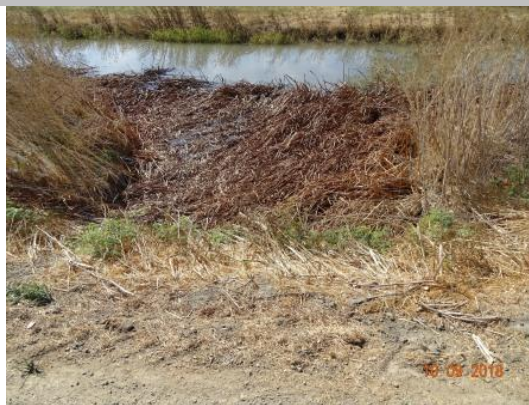
Photo 2 of 2 : SP_2019_NA0010_120_21_20190307_00012.jpg

View of erosion site looking down landside slope. (Fall 2018)

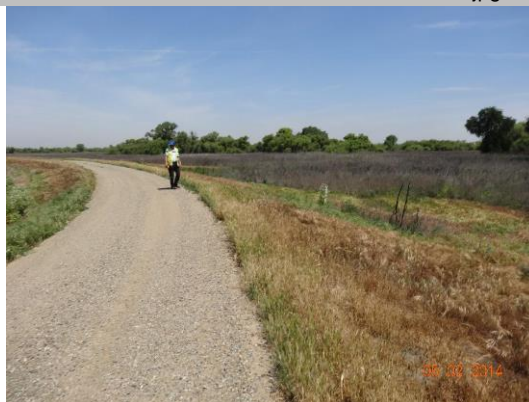
Photo 2 of 3 : UCIP_SP_2019_36531_66240.jpg

Comment Code						
Inspector Comment						
FS_ID:36531 DS_ID:19690 EP_NO: N/A Repair Type: Non-Urgent Crossing Status: Found UCIP Comments: 05/14/2014 Dense vegetation limits the inspector's visibility to identify signs of pipe failure (leaks) along the slope. Recommend removing vegetation along pipe alignment to conduct proper inspection of structure. (DWR UCIP - O. Magana) FIELD_STRUCT_DESC: 24-inch corrugated metal gravity drainage pipe through the levee, 8 feet below the crown. Flap gate on the waterside (WS) end. Screw gate on the landside (LS). [Additional Reference(s): DWR Levee Log, 2002. USACE San Joaquin O&M Manual 601.1, 1967, (HLM 11.43)]. FS Date: 5/14/2014

View of waterward side.

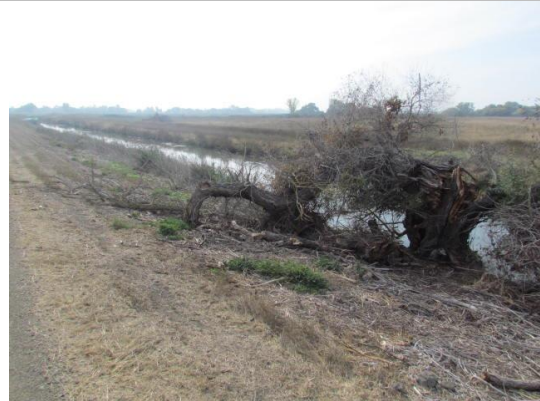
Photo 2 of 2 : SP_2019_NA0010_120_1_20190307_00002.jpg

LM Start	12.21	Rating **	M	Issue No.	1 (cont)	
LM End	12.21	Issue Type +	Ma	Location *	LS	
Category	Earthen Levee			GPS Latitude/Longitude		
				Start		End
Item	Encroachments			37.191528 °		37.191528 °
				-120.764541 °		-120.764541 °
DWR ID	DWR_NA0010_02B_f_2014_1					
Comment Code						
TR : Tree or limb						
Inspector Comment						
Fallen tree limbs are located on the landside slope.

Looking southwest at tree limb on landward slope.

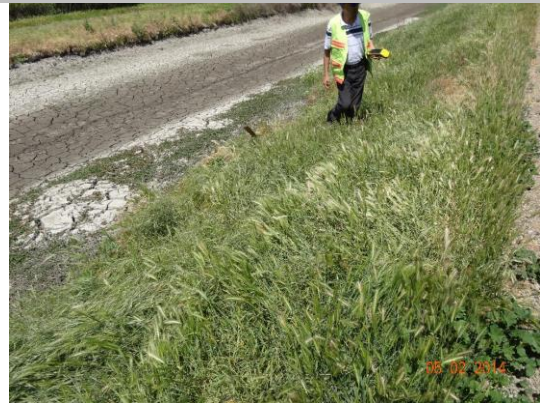
Photo 1 of 3 : UCIP_SP_2019_39370_66245.jpg

Comment Code						
Inspector Comment						
FS_ID:39370						
DS_ID:19663						
EP_NO: N/A						
Repair Type: Non-Urgent						
Crossing Status: Found						
UCIP Comments: 05/14/2014 Dense vegetation limits the inspector's visibility to identify signs of pipe failure (leaks) along the slope.						
Recommend removing vegetation along pipe alignment to conduct proper inspection of structure. Sediment buildup in pipe--recommend clearing. (DWR UCIP - O. Magana)						
FIELD_STRUCT_DESC: 24-inch corrugated metal gravity drainage pipe through the levee, 6.5 feet below the crown. Slide gate in a pipe riser on the waterside (WS) slope. [Additional Reference(s): DWR Levee Log, 2002. USACE San Joaquin O&M Manual 601.1, 1967, (recorded as HLM 13.32 should be 13.22)].						
FS Date: 5/14/2014

View of landward side.

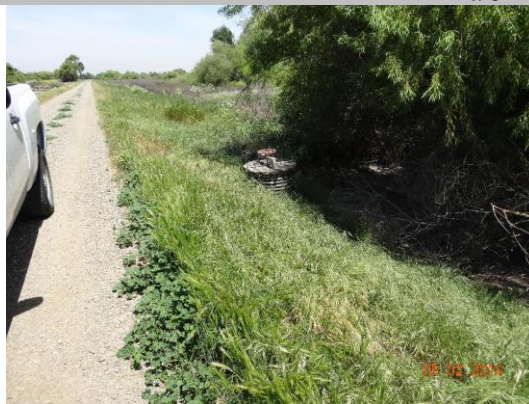
Photo 3 of 3 : UCIP_SP_2019_39370_66243.jpg

Comment Code						
Inspector Comment						
FS_ID:39370 DS_ID:19663 EP_NO: N/A Repair Type: Non-Urgent Crossing Status: Found UCIP Comments: 05/14/2014 Dense vegetation limits the inspector's visibility to identify signs of pipe failure (leaks) along the slope. Recommend removing vegetation along pipe alignment to conduct proper inspection of structure. Sediment buildup in pipe--recommend clearing. (DWR UCIP - O. Magana) FIELD_STRUCT_DESC: 24-inch corrugated metal gravity drainage pipe through the levee, 6.5 feet below the crown. Slide gate in a pipe riser on the waterside (WS) slope. [Additional Reference(s): DWR Levee Log, 2002. USACE San Joaquin O&M Manual 601.1, 1967, (recorded as HLM 13.32 should be 13.22)]. FS Date: 5/14/2014

View of waterward side.

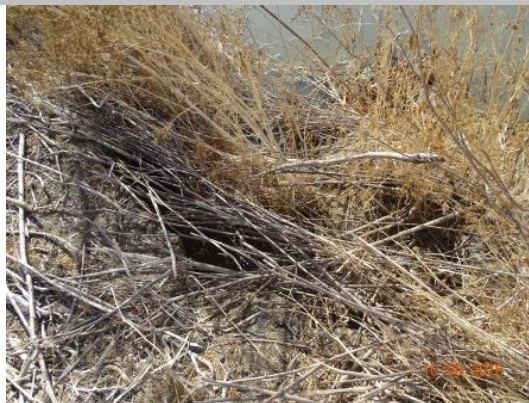
Photo 2 of 2 : SP_2019_NA0010_120_25_20190307_00016.jpg

LM Start	13.72	Rating **	M	Issue No.	25 (cont)	
LM End	13.72	Issue Type +	Ma	Location *	LS	
Category	Earthen Levee			GPS Latitude/Longitude		
				Start		End
Item	Erosion / Bank Caving			37.172648 °		37.172648 °
				-120.761157 °		-120.761157 °
DWR ID	DWR_NA0010_02B_f_2018_25					
Comment Code						
E1 : Note and monitor erosion site.						
Inspector Comment						
Erosion is occurring into the landside bank.

View of erosion on landside slope. (Fall 2018)

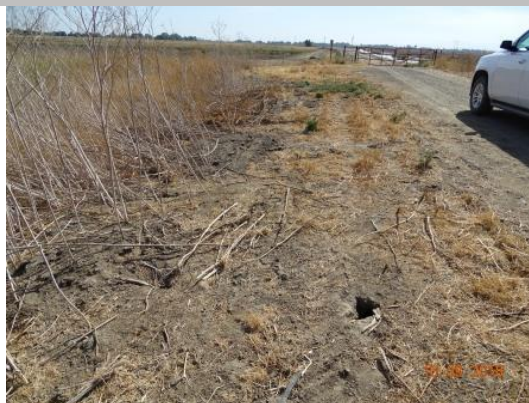
Photo 1 of 2 : SP_2019_NA0010_120_22_20190307_00013.jpg

LM Start	13.73	Rating **	M	Issue No.	22
LM End	13.73	Issue Type +	Ma	Location *	WS
Category	Earthen Levee			GPS Latitude/Longitude	
				Start	End
Item	Animal Control			37.172387 °	37.172387 °
				-120.761190 °	-120.761190 °
DWR ID	DWR_NA0010_02B_f_2018_22				
Comment Code					
A1 : Exterminate rodents and backfill and compact or grout burrows.					
Inspector Comment					
There are several rodent burrows observed at this location

View of waterside slope looking upstream. (Fall 2018)

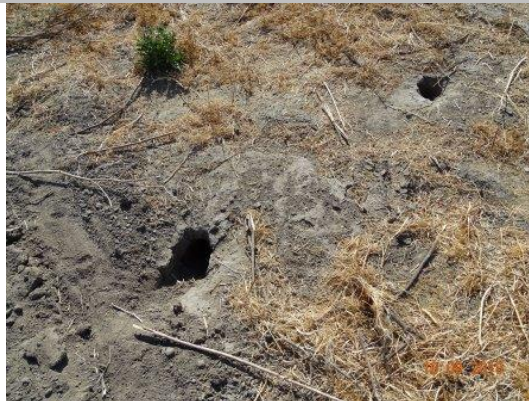
Photo 2 of 2 : SP_2019_NA0010_120_22_20190307_00014.jpg

LM Start	13.73	Rating **	M	Issue No.	22 (cont)
LM End	13.73	Issue Type +	Ma	Location *	WS

Representative view of rodent burrows. (Fall 2018)

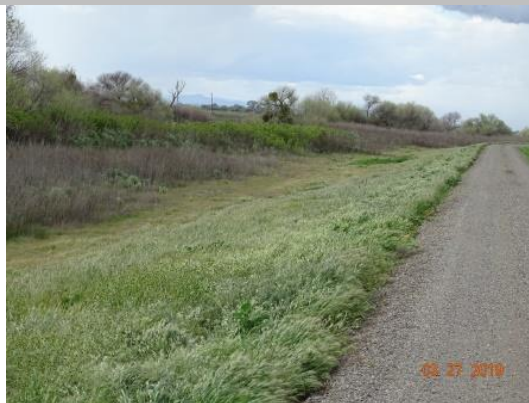
Photo 1 of 1 : SP_2019_NA0010_121_17_20190415_00022.jpg

LM Start	0.02	Rating **	M	Issue No.	17
LM End	2.05	Issue Type +	Ma	Location *	WS
Category	Earthen Levee			GPS Latitude/Longitude	
				Start	End
Item	Vegetation			37.111526 °	37.089304 °
				-120.587691 °	-120.567467 °
DWR ID	DWR_NA0010_03_s_2019_17				
Comment Code					
V1 : Control annual grass and weeds on the levee slopes and easements.					
Inspector Comment

View of waterside slope looking downstream. (Spring 2019)

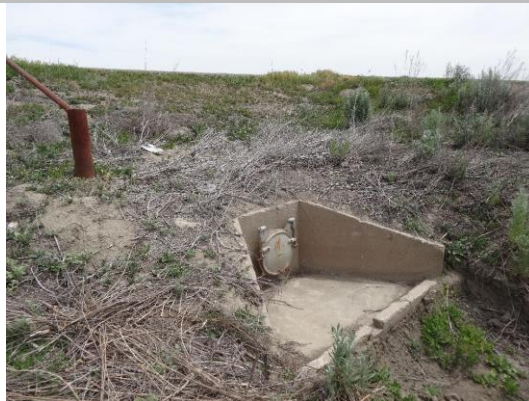
Photo 1 of 3 : UCIP_SP_2019_34083_61941.jpg

LM Start	0.42	Rating **	M	Issue No.	68
LM End	0.42	Issue Type +	Ma	Location *	
Category	Supplemental			GPS Latitude/Longitude	
				Start	End
Item	DWR UCIP LMA Responsibility			37.106233 °	37.106233 °
				-120.585797 °	-120.585797 °
DWR ID	19691				
Comment Code					
Inspector Comment					
FS_ID:34083 DS_ID:19691 EP_NO: N/A Repair Type: Non-Urgent Crossing Status: Found UCIP Comments: 04/17/2014 Need to contact owner. Recommend removing tall grass on landward slope and clearing sediment build up inside pipe. (DWR UCIP - O. Magana) FIELD_STRUCT_DESC: 24-inch corrugated metal gravity drainage pipe through the levee, 11.3 feet below the crown. Flap gate on the waterside (WS) end. [Additional Reference(s): DWR Levee Log, 2002. USACE San Joaquin O&M Manual 601.1, 1967, (HLM 0.43)]. FS Date: 4/17/2014

Concrete structure and flap gate visible on waterward side.

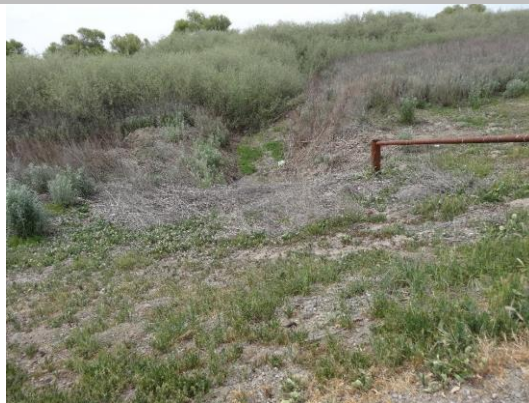
Photo 2 of 3 : UCIP_SP_2019_34083_61940.jpg

LM Start	0.42	Rating **	M	Issue No.	68 (cont)
LM End	0.42	Issue Type +	Ma	Location *

View of waterward side.

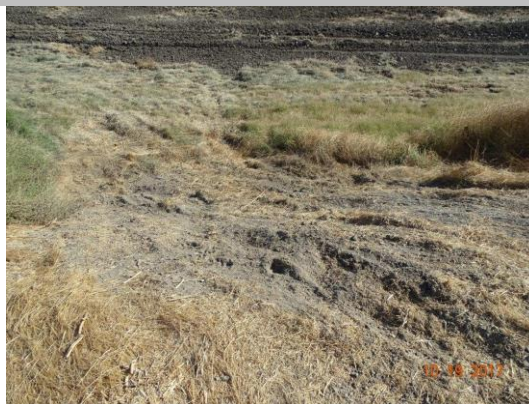
Photo 1 of 1 : SP_2019_NA0010_121_6_20190307_00002.jpg

LM Start	0.43	Rating **	M	Issue No.	6
LM End	0.43	Issue Type +	Ma	Location *	LS
Category	Earthen Levee			GPS Latitude/Longitude	
				Start	End
Item	Slope Stability			37.106121 °	37.106121 °
				-120.585680 °	-120.585680 °
DWR ID	DWR_NA0010_03_f_2017_6				
Comment Code					
S3 : Repair the levee slope damaged by vehicle traffic and prevent access where possible.					
Inspector Comment

Looking east at the landside slope.

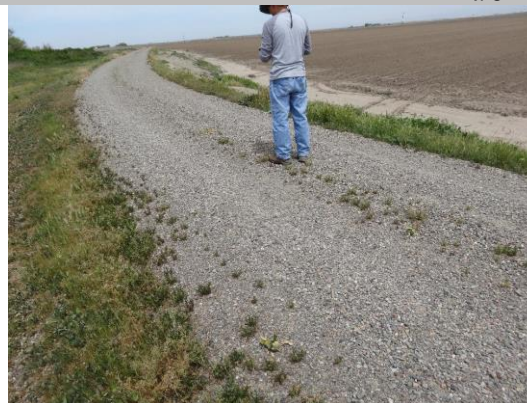
Photo 1 of 3 : UCIP_SP_2019_39371_66252.jpg

LM Start	1.71	Rating **	M	Issue No.	70
LM End	1.71	Issue Type +	Ma	Location *	
Category	Supplemental			GPS Latitude/Longitude	
				Start	End
Item	DWR UCIP LMA Responsibility			37.092079 °	37.092079 °
				-120.572316 °	-120.572316 °
DWR ID	19693				
Comment Code					
Inspector Comment					
FS_ID:39371					
DS_ID:19693					
EP_NO: N/A					
Repair Type: Non-Urgent					
Crossing Status: Found					
UCIP Comments: 04/17/2014 Sediment buildup in pipe visible from landward side--recommend clearing. (DWR UCIP - O. Magana)					
FIELD_STRUCT_DESC: 24-inch corrugated metal gravity drainage pipe through the levee, 6.8 feet below the crown. Flap gate on the waterside (WS) end. [Additional Reference(s): DWR Levee Log, 2002. USACE San Joaquin O&M Manual 601.1, 1967, (HLM 1.72)].					
FS Date: 4/17/2014

View of levee crown at crossing.

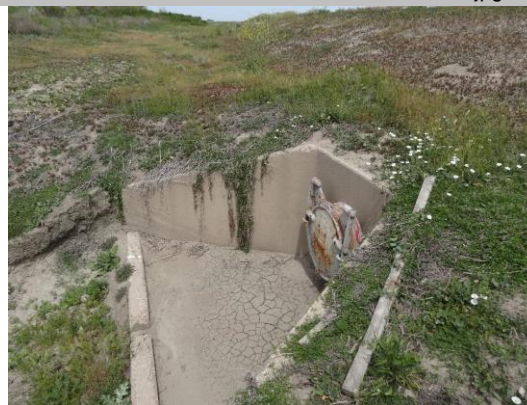
Photo 2 of 3 : UCIP_SP_2019_39371_66254.jpg

LM Start	1.71	Rating **	M	Issue No.	70 (cont)
LM End	1.71	Issue Type +	Ma	Location *

Concrete structure located on waterward side.

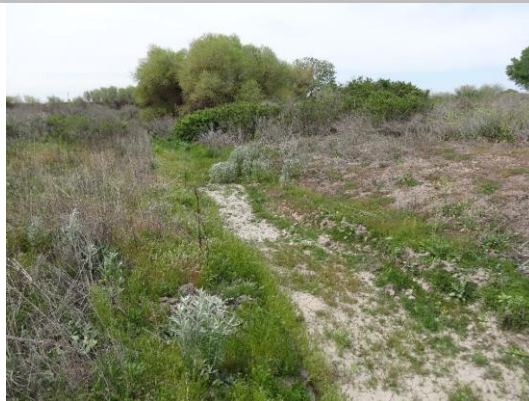
Photo 3 of 3 : UCIP_SP_2019_39371_66253.jpg

LM Start	1.71	Rating **	M	Issue No.	70 (cont)	
LM End	1.71	Issue Type +	Ma	Location *		
Category	Supplemental			GPS Latitude/Longitude		
				Start	End	
Item	DWR UCIP LMA Responsibility			37.092079 °	37.092079 °	
				-120.572316 °	-120.572316 °	
DWR ID	19693					
Comment Code						
Inspector Comment						
FS_ID:39371						
DS_ID:19693						
EP_NO: N/A						
Repair Type: Non-Urgent						
Crossing Status: Found						
UCIP Comments: 04/17/2014 Sediment buildup in pipe visible from landward side--recommend clearing. (DWR UCIP - O. Magana)						
FIELD_STRUCT_DESC: 24-inch corrugated metal gravity drainage pipe through the levee, 6.8 feet below the crown. Flap gate on the waterside (WS) end. [Additional Reference(s): DWR Levee Log, 2002. USACE San Joaquin O&M Manual 601.1, 1967, (HLM 1.72)].						
FS Date: 4/17/2014

View of waterward side--channel.

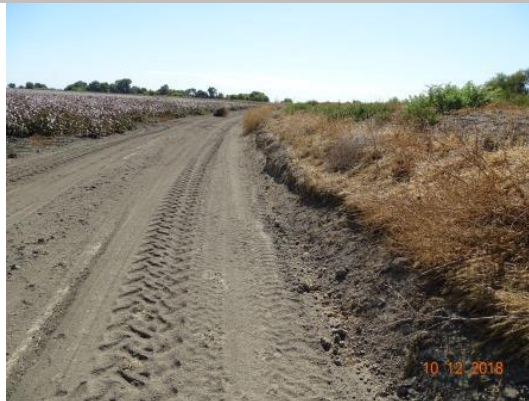
Photo 1 of 1 : SP_2019_NA0010_121_13_20190307_00007.jpg

LM Start	1.74	Rating **	M	Issue No.	13
LM End	1.87	Issue Type +	En	Location *	LS
Category	Earthen Levee			GPS Latitude/Longitude	
				Start	End
Item	Encroachments			37.091698 °	37.090338 °
				-120.572058 °	-120.570537 °
DWR ID	DWR_NA0010_03_f_2018_13				
Comment Code					
AT : Agricultural tilling					
Inspector Comment					
Landside slope has been cut in to by farming equipment.

View of landside slope at toe where levee has been cut in. (Fall 2018)

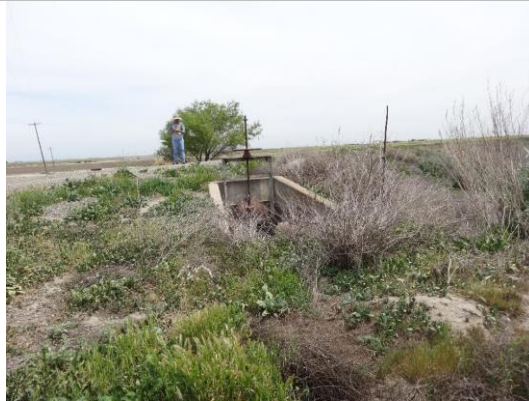
Photo 1 of 3 : UCIP_SP_2019_36543_66281.jpg

Comment Code					
Inspector Comment					
FS_ID:36543 DS_ID:19694 EP_NO: N/A Repair Type: Non-Urgent Crossing Status: Found UCIP Comments: 04/17/2014 Need to contact owner--additional appurtenances found on waterward side not part of original description. Unable to determine if walkway, pump, and pipe through waterward berm is if part of original crossing. (DWR UCIP - O. Magana) FIELD_STRUCT_DESC: 36-inch corrugated metal irrigation discharge pipe through the levee, 6.6 feet below the crown. Pump on the riverbank. Slide gate on the waterside (WS) end. [Additional Reference(s): DWR Levee Log, 2002. USACE San Joaquin O&M Manual 601.1, 1967, (HLM 2.05)]. FS Date: 4/17/2014

Slide gate and concrete structure located on waterward slope.

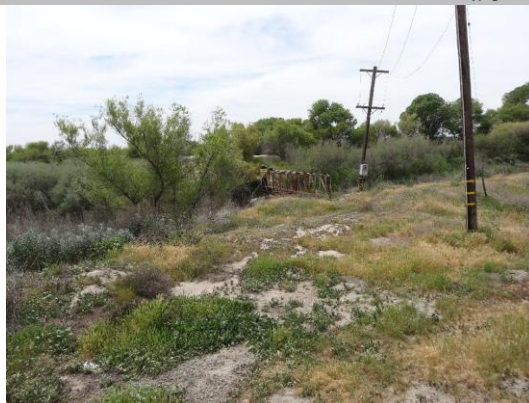
Photo 2 of 3 : UCIP_SP_2019_36543_66282.jpg

View of walkway and berm on waterward side.
