**Flood Control Project Maintenance
Levee Inspections**
LMA District Cover Sheet
Spring 2019 Levee Inspection Results

Lower San Joaquin Levee District

Spring 2019 Levee Inspection Results

Waterway			Bank	Unit Miles
Unit No. 01 San Joaquin River			Right	22.52
	Spring (March - May)	Summer (June - August)	(September - November) Fall	Winter (December - February)
Unit Maintenance Rating (Fall Only)				
Date of Inspection	3/26/2019 - 3/26/2019			
DWR Inspector	Corey Fujitani			
Accompanied By

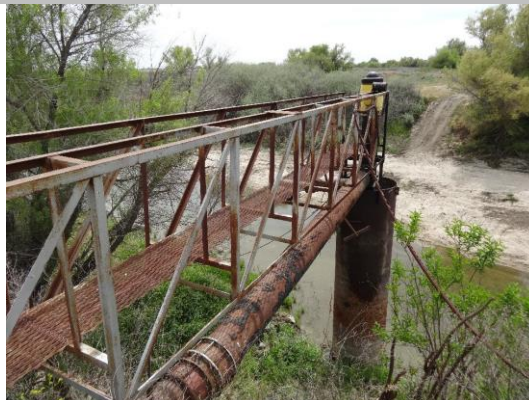
Photo 3 of 3 : UCIP_SP_2019_36543_66280.jpg

Pump and damage walkway located on waterward side.

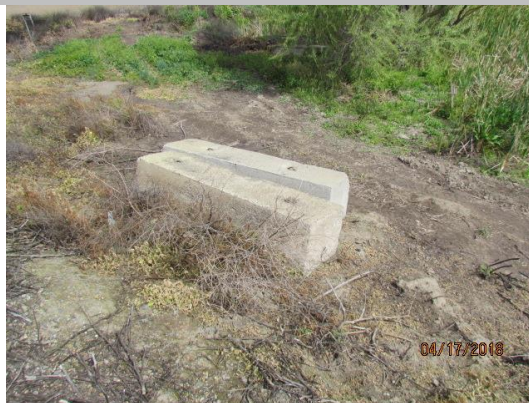
Photo 1 of 1 : SP_2019_NA0010_121_5_20190307_00001.jpg

LM Start	2.05	Rating **	U	Issue No.	5
LM End	2.05	Issue Type +	En	Location *	LS
Category	Earthen Levee			GPS Latitude/Longitude	
				Start	End
Item	Encroachments			37.089289 °	37.089289 °
				-120.567463 °	-120.567463 °
DWR ID	DWR_NA0010_03_s_2018_5				
Comment Code					
MA : Material					
Inspector Comment					
Two large concrete blocks are located on the landward toe.

Looking southwest at concrete blocks on landward toe. (Spring 2018)

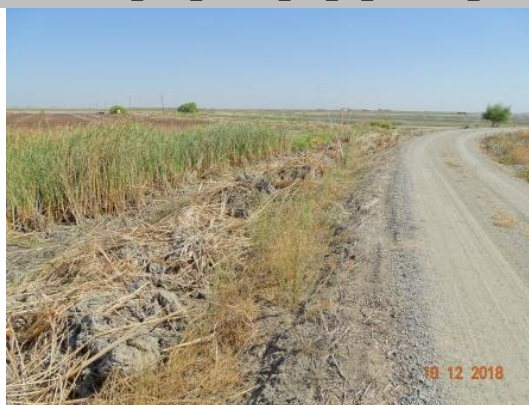
Photo 1 of 1 : SP_2019_NA0010_121_14_20190307_00008.jpg

LM Start	2.07	Rating **	U	Issue No.	14
LM End	2.09	Issue Type +	En	Location *	LS
Category	Earthen Levee			GPS Latitude/Longitude	
				Start	End
Item	Encroachments			37.089177 °	37.089070 °
				-120.567126 °	-120.566977 °
DWR ID	DWR_NA0010_03_f_2018_14				
Comment Code					
DE : Debris					
Inspector Comment					
Debris from ditch dredging left on slope.

View of debris from dredging left on landside slope. (Fall 2018)

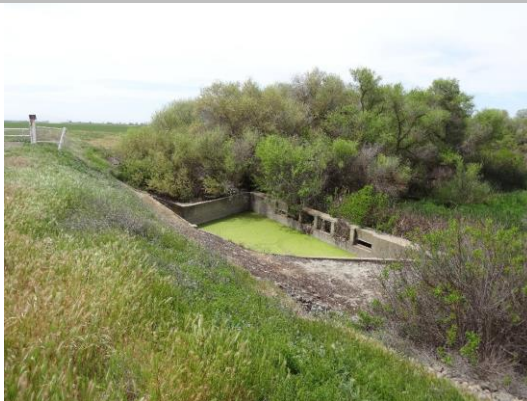
Photo 1 of 3 : UCIP_SP_2019_40529_61969.jpg

View of concrete structure located on landward side.

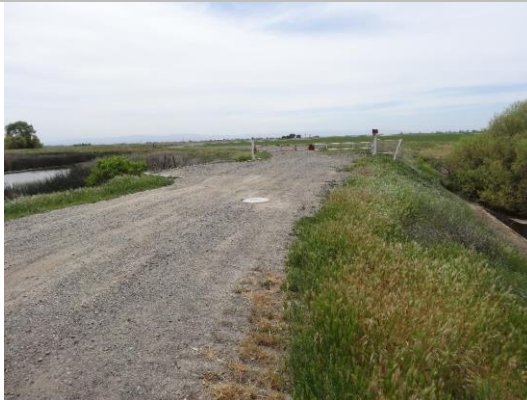
Photo 2 of 3 : UCIP_SP_2019_40529_61968.jpg

View of levee crown.

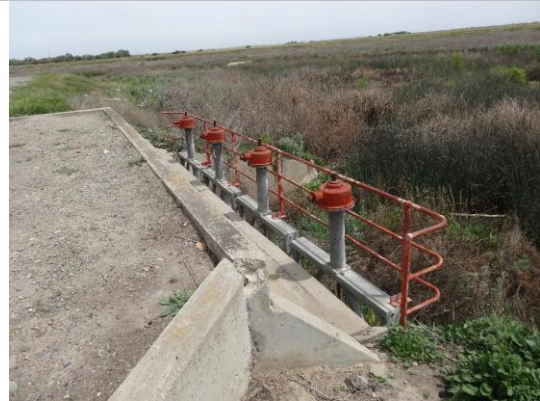
Photo 3 of 3 : UCIP_SP_2019_40529_61967.jpg

Comment Code						
Inspector Comment						
FS_ID:40529 DS_ID:19977 EP_NO: 5024 Repair Type: Non-Urgent Crossing Status: Found UCIP Comments: 04/17/2014 Slide gates blocked by sediment. Recommend contacting owner to determine status of crossing. Crossing appears to be abandoned. (DWR UCIP - O. Magana) FIELD_STRUCT_DESC: [San Joaquin River Diversion Structure] 1 of 4: 72-inch by 60-inch reinforced concrete box gravity drainage culvert through the levee, 21 feet below the crown. Slide gate on the waterside (WS). Concrete headwall on each end. Landside (LS) slope cobble revetted. Flashboards on the downstream side of the structure. FS Date: 4/17/2014

Concrete headwall located on waterward side.

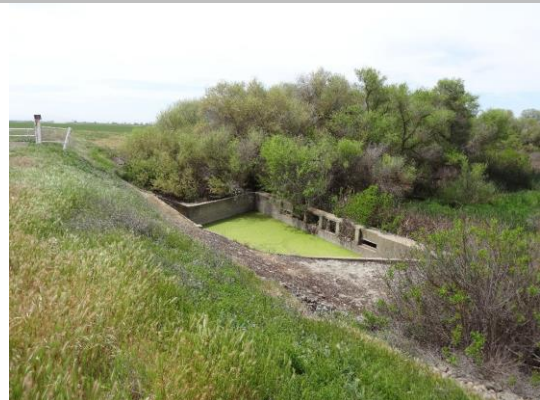
Photo 1 of 3 : UCIP_SP_2019_36875_67308.jpg

Comment Code					
Inspector Comment					
FS_ID:36875					
DS_ID:24856					
EP_NO: 5024					
Repair Type: Non-Urgent					
Crossing Status: Found					
UCIP Comments: 04/17/2014 Slide gates blocked by sediment.					
Recommend contacting owner to determine status of crossing.					
Crossing appears to be abandoned. (DWR UCIP - O. Magana)					
FIELD_STRUCT_DESC: [San Joaquin River Diversion Structure] 2 of 4:					
72-inch by 60-inch reinforced concrete box gravity drainage culvert					
through the levee, 21 feet below the crown. Slide gate on the waterside					
(WS). Concrete headwall on each end. Landside (LS) slope cobble					
revetted. Flashboards on the downstream side of the structure.					
FS Date: 4/17/2014

View of concrete structure located on landward side.

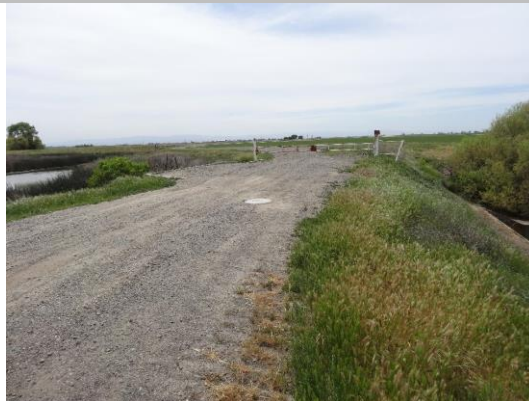
Photo 2 of 3 : UCIP_SP_2019_36875_67307.jpg

View of levee crown.

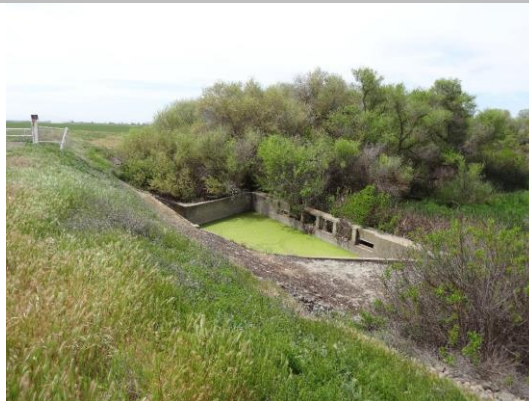
Photo 1 of 3 : UCIP_SP_2019_36876_67318.jpg

Comment Code						
Inspector Comment						
FS_ID:36876						
DS_ID:24857						
EP_NO: 5024						
Repair Type: Non-Urgent						
Crossing Status: Found						
UCIP Comments: 04/17/2014 Slide gates blocked by sediment.						
Recommend contacting owner to determine status of crossing.						
Crossing appears to be abandoned. (DWR UCIP - O. Magana)						
FIELD_STRUCT_DESC: [San Joaquin River Diversion Structure] 3 of 4:						
72-inch by 60-inch reinforced concrete box gravity drainage culvert						
through the levee, 21 feet below the crown. Slide gate on the waterside						
(WS). Concrete headwall on each end. Landside (LS) slope cobble						
revetted. Flashboards on the downstream side of the structure.						
FS Date: 4/17/2014

View of concrete structure located on landward side.

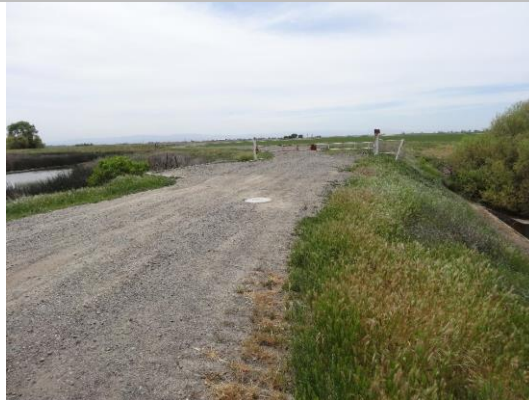
Photo 2 of 3 : UCIP_SP_2019_36876_67317.jpg

View of levee crown.

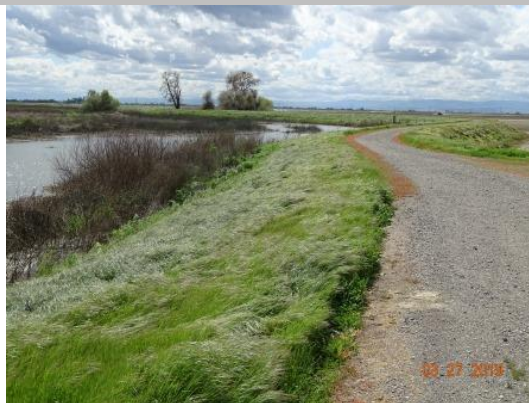
Photo 1 of 1 : SP_2019_NA0010_122_10_20190416_00025.jpg

LM Start	0.05	Rating **	M	Issue No.	10
LM End	0.32	Issue Type +	Ma	Location *	WS
Category	Earthen Levee			GPS Latitude/Longitude	
				Start	End
Item	Vegetation			37.112255 °	37.108807 °
				-120.589794 °	-120.590752 °
DWR ID	DWR_NA0010_04_s_2019_10				
Comment Code					
V1 : Control annual grass and weeds on the levee slopes and easements.					
Inspector Comment

View of waterside slope looking upstream. (Spring 2019)

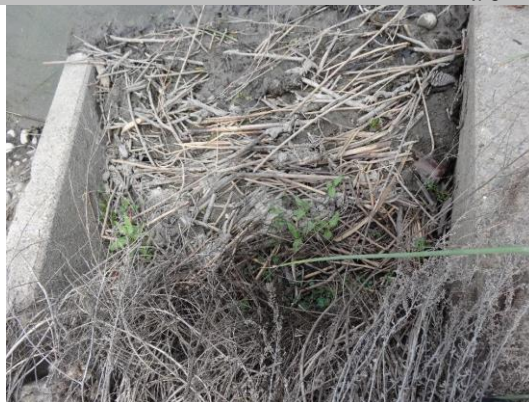
Photo 2 of 3 : UCIP_SP_2019_34093_61981.jpg

Sediment blocking flap gate located on waterward side.

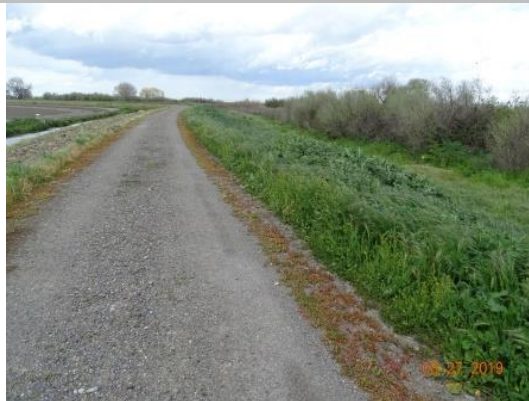
Photo 1 of 1 : SP_2019_NA0010_122_12_20190416_00027.jpg

LM Start	0.32	Rating **	U	Issue No.	12
LM End	1.40	Issue Type +	Ma	Location *	WS
Category	Earthen Levee			GPS Latitude/Longitude	
				Start	End
Item	Vegetation			37.108807 °	37.097702 °
				-120.590752 °	-120.578154 °
DWR ID	DWR_NA0010_04_s_2019_12				
Comment Code					
V1 : Control annual grass and weeds on the levee slopes and easements.					
Inspector Comment

View of waterside slope looking downstream. (Spring 2019)

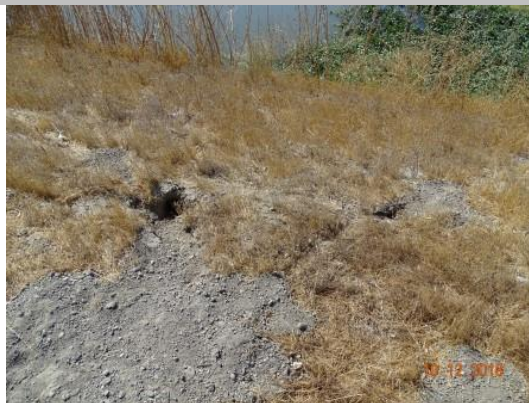
Photo 1 of 1 : SP_2019_NA0010_122_11_20190307_00006.jpg

LM Start	0.48	Rating **	A/W	Issue No.	11
LM End	0.48	Issue Type +	Ma	Location *	LS
Category	Earthen Levee			GPS Latitude/Longitude	
				Start	End
Item	Animal Control			37.106754 °	37.106754 °
				-120.589459 °	-120.589459 °
DWR ID	DWR_NA0010_04_f_2018_11				
Comment Code					
A3 : No rodents visible, but rodent burrows visible; need to backfill and compact or grout burrows.					
Inspector Comment					
Several rodent holes were observed in landside shoulder and slope.

Rodent burrows in landside shoulder and slope. (Fall 2018)

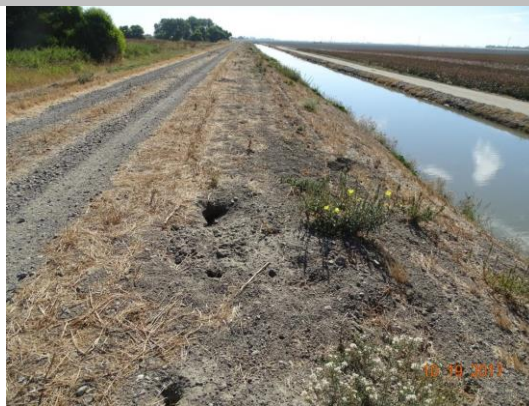
Photo 1 of 1 : SP_2019_NA0010_122_8_20190307_00004.jpg

LM Start	0.55	Rating **	M	Issue No.	8
LM End	0.55	Issue Type +	Ma	Location *	LS
Category	Earthen Levee			GPS Latitude/Longitude	
				Start	End
Item	Animal Control			37.105957 °	37.105957 °
				-120.588684 °	-120.588684 °
DWR ID	DWR_NA0010_04_f_2017_8				
Comment Code					
A3 : No rodents visible, but rodent burrows visible; need to backfill and compact or grout burrows.					
Inspector Comment

Looking south at landside slope.

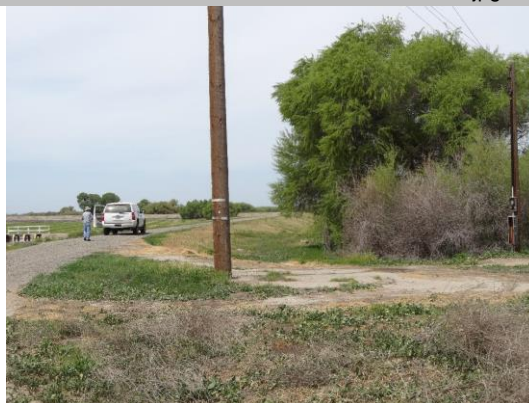
Photo 2 of 3 : UCIP_SP_2019_40530_61988.jpg

Overview of waterward side and levee crown at crossing.

LM Start	1.34	Rating **	M	Issue No.	18 (cont)	
LM End	1.34	Issue Type +	En	Location *		
Category	Supplemental			GPS Latitude/Longitude		
				Start	End	
Item	DWR UCIP Field Study			37.095274 °	37.095274 °	
				-120.577959 °	-120.577959 °	
DWR ID	19975					
Comment Code						
Inspector Comment						
FS_ID:40530						
DS_ID:19975						
EP_NO: 3416						
Repair Type: Non-Urgent						
Crossing Status: Found						
UCIP Comments: Unable to confirm if crossing is still in use. Need to contact owner to confirm status.						
FIELD_STRUCT_DESC: 12-inch steel irrigation pipe, encased in 6-inches of reinforced concrete through the levee. Concrete cutoff wall at center of levee. Pumping plant on the waterward bank. Pump and irrigation pipe retained under Permit No. 3416 (1964).						
FS Date: 4/17/2014

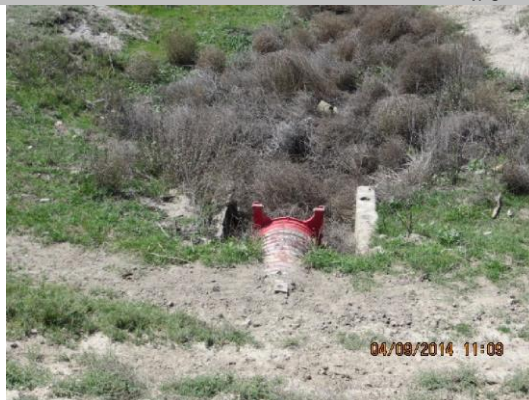
Photo 1 of 3 : UCIP_SP_2019_39563_60921.jpg

LM Start	0.08	Rating **	M	Issue No.	1310
LM End	0.08	Issue Type +	Ma	Location *	
Category	Supplemental			GPS Latitude/Longitude	
				Start	End
Item	DWR UCIP LMA Responsibility			37.278174 °	37.278174 °
				-120.823465 °	-120.823465 °
DWR ID	19756				
Comment Code					
Inspector Comment					
FS_ID:39563 DS_ID:19756 EP_NO: N/A Repair Type: Non-Urgent Crossing Status: Found UCIP Comments: 04/09/2014 Debris blocking landward headwall--recommend clearing. (DWR UCIP - W. Wylie) FIELD_STRUCT_DESC: 24-inch corrugated metal gravity drainage pipe through the levee, 8.6 feet below the crown. Concrete U-shaped headwall and flap gate on the waterside (WS) end. Concrete headwall on the landside (LS) end. [Additional Reference(s): DWR Levee Log, 2002. USACE San Joaquin O&M Manual 601.1, 1967, (HLM 0.07)]. FS Date: 4/9/2014

Pipe, flapgate, and concrete headwall on WS toe.

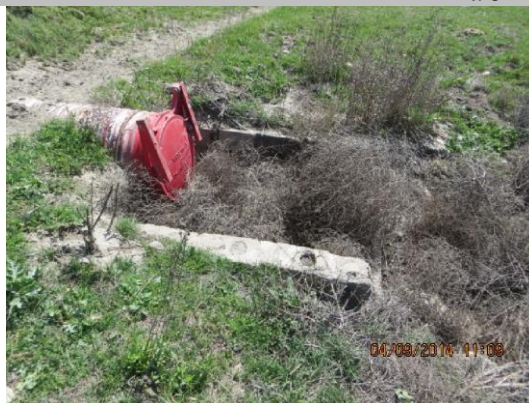
Photo 2 of 3 : UCIP_SP_2019_39563_60920.jpg

Pipe, flapgate, and concrete headwall on WS toe.

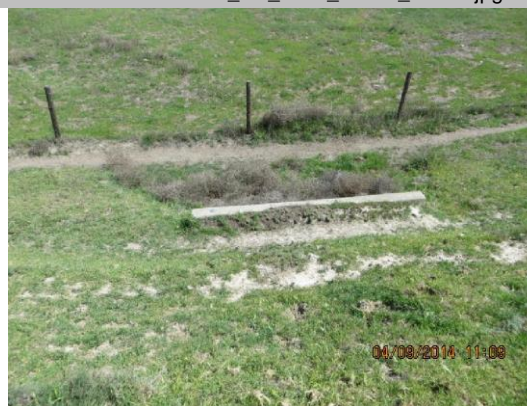
Photo 3 of 3 : UCIP_SP_2019_39563_60922.jpg

LM Start	0.08	Rating **	M	Issue No.	1310 (cont)	
LM End	0.08	Issue Type +	Ma	Location *		
Category	Supplemental			GPS Latitude/Longitude		
				Start	End	
Item	DWR UCIP LMA Responsibility			37.278174 °	37.278174 °	
				-120.823465 °	-120.823465 °	
DWR ID	19756					
Comment Code						
Inspector Comment						
FS_ID:39563 DS_ID:19756 EP_NO: N/A Repair Type: Non-Urgent Crossing Status: Found UCIP Comments: 04/09/2014 Debris blocking landward headwall--recommend clearing. (DWR UCIP - W. Wylie) FIELD_STRUCT_DESC: 24-inch corrugated metal gravity drainage pipe through the levee, 8.6 feet below the crown. Concrete U-shaped headwall and flap gate on the waterside (WS) end. Concrete headwall on the landside (LS) end. [Additional Reference(s): DWR Levee Log, 2002. USACE San Joaquin O&M Manual 601.1, 1967, (HLM 0.07)]. FS Date: 4/9/2014

Pipe and concrete headwall on LS toe.

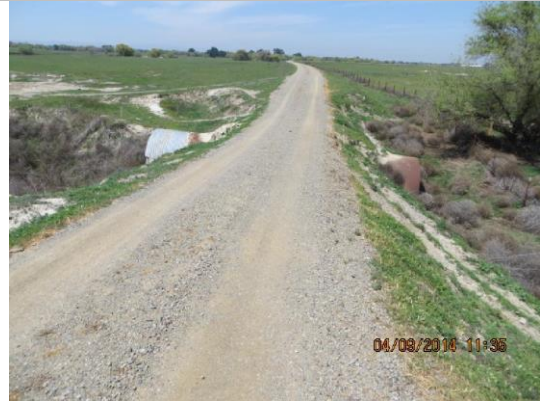
Photo 1 of 3 : UCIP_SP_2019_53185_71469.jpg

Comment Code						
Inspector Comment						
FS_ID:53185 DS_ID:24867 EP_NO: N/A Repair Type: Urgent Crossing Status: Found UCIP Comments: 11/01/2018 Same as previous inspection, 1960s levee breach; degraded levee section that drops about 4 feet within a 100-foot levee section. Crossing remains Urgent due to the levee degradation at this location. (O. Magana - DWR UCIP)07/20/2016 same as previous inspection. Levee section at crossing has been degraded. According to LMA representative, Rick, the low point at crossing has been present for over 10 years when the pipe was replaced. (DWR UCIP - O. Magana)04/09/2014 Pipe is open on both ends and levee has been degraded at this location. No permit identified for this crossing. (DWR UCIP - W. Wylie) FIELD_STRUCT_DESC: 96-inch corrugated metal gravity drainage pipe through the levee, 4.5 feet below the crown. Pipe is composed of two materials: corrugated metal pipe (CMP) on the waterside (WS) and steel pipe on the landside (LS). This section of the levee is a degraded section that drops approximately 4 feet within 100 feet of length. This section of the levee is the site of the 1960s levee breach. [Additional Reference(s): USACE Periodic Inspection Report 2014, USACE_CESPK_L05A_2014_p_0014]. FS Date: 11/1/2018 12:48:00 PM

Pipe through levee where levee has been degraded.

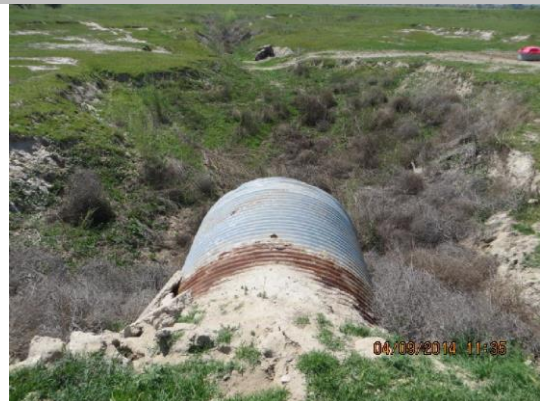
Photo 2 of 3 : UCIP_SP_2019_53185_71467.jpg

Pipe on WS toe.

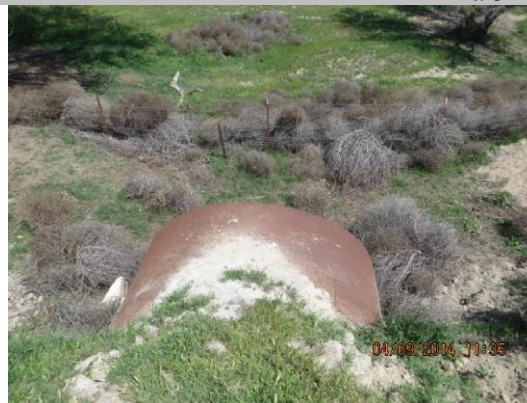
Photo 3 of 3 : UCIP_SP_2019_53185_71468.jpg

Comment Code						
Inspector Comment						
FS_ID:53185 DS_ID:24867 EP_NO: N/A Repair Type: Urgent Crossing Status: Found UCIP Comments: 11/01/2018 Same as previous inspection, 1960s levee breach; degraded levee section that drops about 4 feet within a 100-foot levee section. Crossing remains Urgent due to the levee degradation at this location. (O. Magana - DWR UCIP)07/20/2016 same as previous inspection. Levee section at crossing has been degraded. According to LMA representative, Rick, the low point at crossing has been present for over 10 years when the pipe was replaced. (DWR UCIP - O. Magana)04/09/2014 Pipe is open on both ends and levee has been degraded at this location. No permit identified for this crossing. (DWR UCIP - W. Wylie) FIELD_STRUCT_DESC: 96-inch corrugated metal gravity drainage pipe through the levee, 4.5 feet below the crown. Pipe is composed of two materials: corrugated metal pipe (CMP) on the waterside (WS) and steel pipe on the landside (LS). This section of the levee is a degraded section that drops approximately 4 feet within 100 feet of length. This section of the levee is the site of the 1960s levee breach. [Additional Reference(s): USACE Periodic Inspection Report 2014, USACE_CESPK_L05A_2014_p_0014]. FS Date: 11/1/2018 12:48:00 PM

Pipe on LS toe.

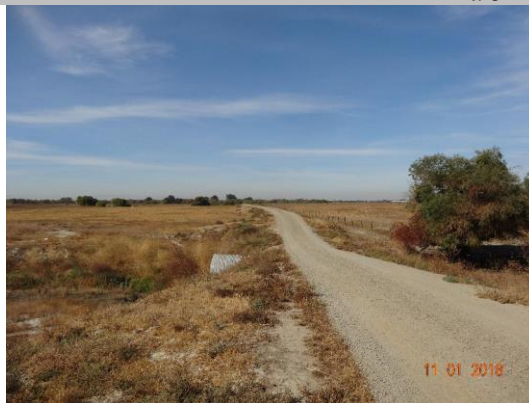
Photo 1 of 3 : UCIP_SP_2019_53194_78592.jpg

Comment Code					
Inspector Comment					
FS_ID:53194 DS_ID:19557 EP_NO: N/A Repair Type: Non-Urgent Crossing Status: Indicator Found UCIP Comments: 11/01/2018 24-inch corrugated metal pipe (CMP) section found during pipe inspection of dsid 24867 (see photos); according to LMA representative levee section is the location of levee breach from 1960s; 24-inch pipe was undersized and was replaced after levee breach with a 96-inch CMP and steel pipe. FIELD_STRUCT_DESC: 24-inch corrugated metal gravity drainage pipe through the levee, 5.6 feet below the crown. Flap gate on the waterside (WS) end. Large pipe found at this location. [Additional Reference(s): USACE San Joaquin O&M Manual 601.1, 1967, (HLM 0.30)]. FS Date: 4/9/2014

Overview of degraded levee section.

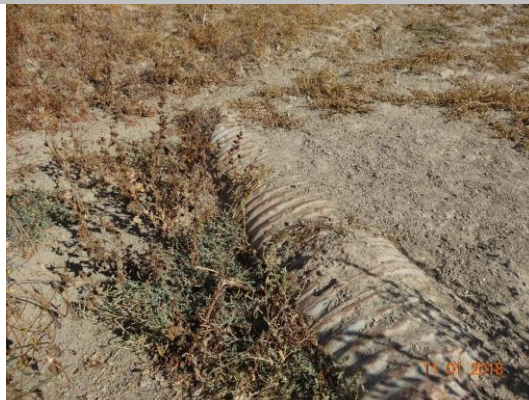
Photo 2 of 3 : UCIP_SP_2019_53194_78593.jpg

LS view: CMP section found on LS.

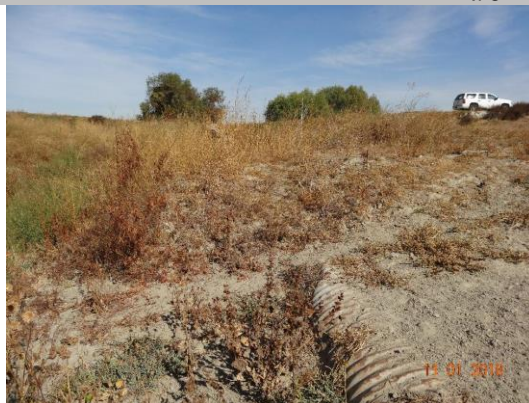
Photo 3 of 3 : UCIP_SP_2019_53194_78594.jpg

Comment Code						
Inspector Comment						
FS_ID:53194 DS_ID:19557 EP_NO: N/A Repair Type: Non-Urgent Crossing Status: Indicator Found UCIP Comments: 11/01/2018 24-inch corrugated metal pipe (CMP) section found during pipe inspection of dsid 24867 (see photos); according to LMA representative levee section is the location of levee breach from 1960s; 24-inch pipe was undersized and was replaced after levee breach with a 96-inch CMP and steel pipe. FIELD_STRUCT_DESC: 24-inch corrugated metal gravity drainage pipe through the levee, 5.6 feet below the crown. Flap gate on the waterside (WS) end. Large pipe found at this location. [Additional Reference(s): USACE San Joaquin O&M Manual 601.1, 1967, (HLM 0.30)]. FS Date: 4/9/2014

LS view: 24-inch pipe section found west of LS toe.

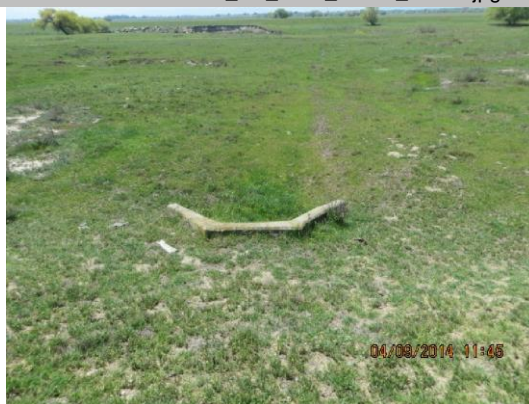
Photo 1 of 3 : UCIP_SP_2019_39584_60926.jpg

LM Start	0.60	Rating **	M	Issue No.	1313
LM End	0.60	Issue Type +	Ma	Location *	
Category	Supplemental			GPS Latitude/Longitude	
				Start	End
Item	DWR UCIP LMA Responsibility			37.273945 °	37.273945 °
				-120.815835 °	-120.815835 °
DWR ID	19757				
Comment Code					
Inspector Comment					
FS_ID:39584 DS_ID:19757 EP_NO: N/A Repair Type: Non-Urgent Crossing Status: Found UCIP Comments: 04/09/2014 Excess debris on landward headwall--recommend clearing. (DWR UCIP - W. Wylie) FIELD_STRUCT_DESC: 30-inch corrugated metal gravity drainage pipe through the levee, 7.5 feet below the crown. Flap gate on the waterside (WS) end. Concrete headwall on the landside (LS) end. Concrete U-shaped headwall on the WS end. [Additional Reference(s): DWR Levee Log, 2002. USACE San Joaquin O&M Manual 601.1, 1967, (HLM 0.59)]. FS Date: 4/9/2014

Concrete headwall, pipe, and flapgate on WS toe.

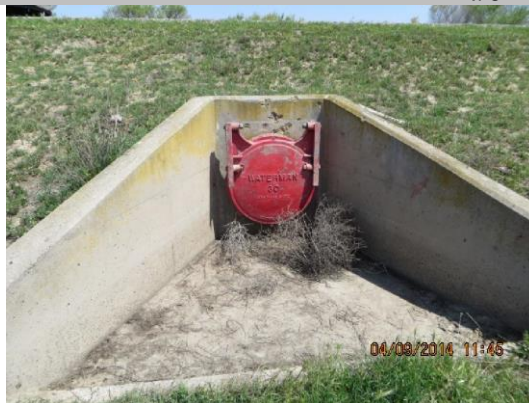
Photo 2 of 3 : UCIP_SP_2019_39584_60925.jpg

LM Start	0.60	Rating **	M	Issue No.	1313 (cont)	
LM End	0.60	Issue Type +	Ma	Location *		
Category	Supplemental			GPS Latitude/Longitude		
				Start		End
Item	DWR UCIP LMA Responsibility			37.273945 °		37.273945 °
				-120.815835 °		-120.815835 °
DWR ID	19757					
Comment Code						
Inspector Comment						
FS_ID:39584 DS_ID:19757 EP_NO: N/A Repair Type: Non-Urgent Crossing Status: Found UCIP Comments: 04/09/2014 Excess debris on landward headwall--recommend clearing. (DWR UCIP - W. Wylie) FIELD_STRUCT_DESC: 30-inch corrugated metal gravity drainage pipe through the levee, 7.5 feet below the crown. Flap gate on the waterside (WS) end. Concrete headwall on the landside (LS) end. Concrete U-shaped headwall on the WS end. [Additional Reference(s): DWR Levee Log, 2002. USACE San Joaquin O&M Manual 601.1, 1967, (HLM 0.59)]. FS Date: 4/9/2014

Concrete headwall, pipe, and flapgate on WS toe.

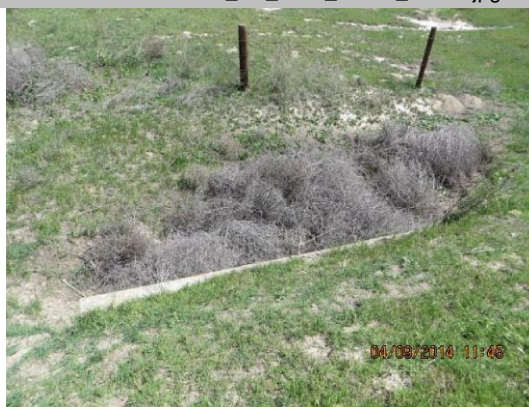
Photo 3 of 3 : UCIP_SP_2019_39584_60927.jpg

Pipe and concrete headwall on LS toe. Note vegetation buildup.

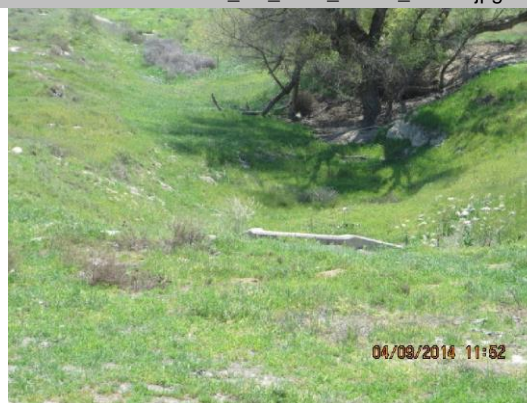
Photo 1 of 3 : UCIP_SP_2019_39585_60931.jpg

Comment Code					
Inspector Comment					
FS_ID:39585 DS_ID:19758 EP_NO: N/A Repair Type: Non-Urgent Crossing Status: Found UCIP Comments: 04/09/2014 Dense vegetation limits the inspector's visibility to identify signs of pipe failure (leaks) along the landward slope. Recommend removing vegetation along pipe alignment to conduct proper inspection of structure. (DWR UCIP - W. Wylie) FIELD_STRUCT_DESC: 36-inch corrugated metal gravity drainage pipe through the levee, 13.2 feet below the crown. Flap gate on the waterside (WS) end. Concrete headwall on the landside (LS) end. Concrete U-shaped headwall on the WS end. Cobble revetment around both ends. [Additional Reference(s): DWR Levee Log, 2002. USACE San Joaquin O&M Manual 601.1, 1967, (HLM 0.65)]. FS Date: 4/9/2014

Concrete headwall visible off WS toe.

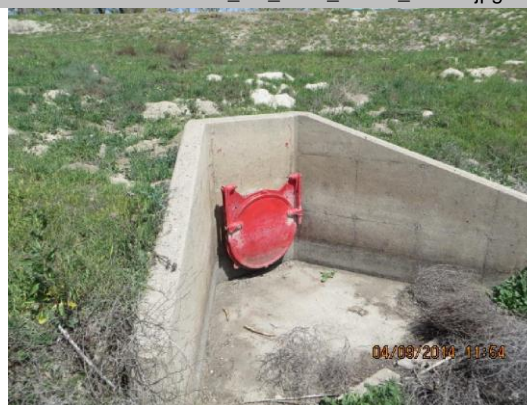
Photo 2 of 3 : UCIP_SP_2019_39585_60929.jpg

Pipe, flapgate, and headwall at WS toe.

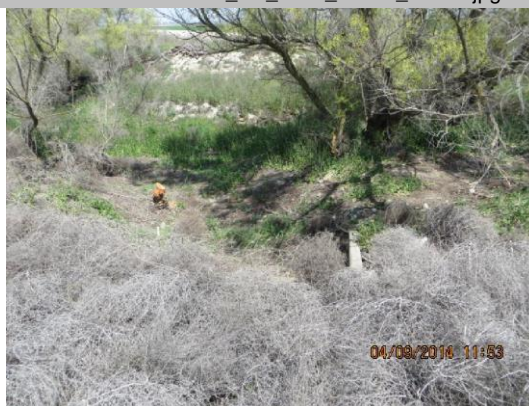
Photo 3 of 3 : UCIP_SP_2019_39585_60930.jpg

Comment Code						
Inspector Comment						
FS_ID:39585 DS_ID:19758 EP_NO: N/A Repair Type: Non-Urgent Crossing Status: Found UCIP Comments: 04/09/2014 Dense vegetation limits the inspector's visibility to identify signs of pipe failure (leaks) along the landward slope. Recommend removing vegetation along pipe alignment to conduct proper inspection of structure. (DWR UCIP - W. Wylie) FIELD_STRUCT_DESC: 36-inch corrugated metal gravity drainage pipe through the levee, 13.2 feet below the crown. Flap gate on the waterside (WS) end. Concrete headwall on the landside (LS) end. Concrete U-shaped headwall on the WS end. Cobble revetment around both ends. [Additional Reference(s): DWR Levee Log, 2002. USACE San Joaquin O&M Manual 601.1, 1967, (HLM 0.65)]. FS Date: 4/9/2014

Concrete headwall at LS toe.

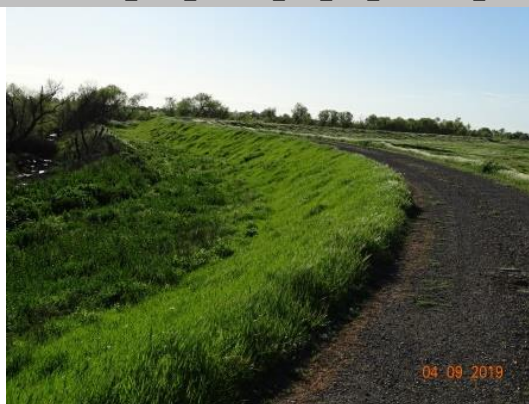
Photo 1 of 1 : SP_2019_NA0010_123_100_20190422_00334.jpg

LM Start	0.66	Rating **	M	Issue No.	100
LM End	3.63	Issue Type +	Ma	Location *	LS
Category	Earthen Levee			GPS Latitude/Longitude	
				Start	End
Item	Vegetation			37.273299 °	37.252951 °
				-120.815011 °	-120.768351 °
DWR ID	DWR_NA0010_05_s_2019_100				
Comment Code					
V1 : Control annual grass and weeds on the levee slopes and easements.					
Inspector Comment

View of landside slope looking upstream. (Spring 2019)

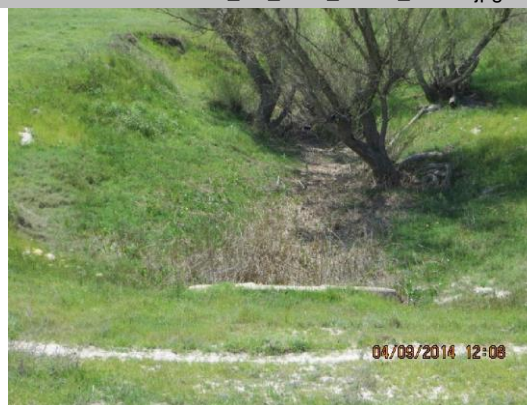
Photo 1 of 3 : UCIP_SP_2019_33707_60934.jpg

LM Start	0.85	Rating **	A/W	Issue No.	1315
LM End	0.85	Issue Type +	Ma	Location *	
Category	Supplemental			GPS Latitude/Longitude	
				Start	End
Item	DWR UCIP LMA Responsibility			37.271894 °	37.271894 °
				-120.812224 °	-120.812224 °
DWR ID	19759				
Comment Code					
Inspector Comment					
FS_ID:33707 DS_ID:19759 EP_NO: N/A Repair Type: No Action Needed Crossing Status: Found UCIP Comments: FIELD_STRUCT_DESC: 24-inch corrugated metal gravity drainage pipe through the levee, 14.4 feet below the crown. Flap gate on the waterside (WS) end. Concrete headwall on the landside (LS) end. Concrete U-shaped headwall on the WS end. [Additional Reference(s): DWR Levee Log, 2002. USACE San Joaquin O&M Manual 601.1, 1967, (HLM 0.84)]. FS Date: 4/9/2014

Concrete headwall visible at LS toe.

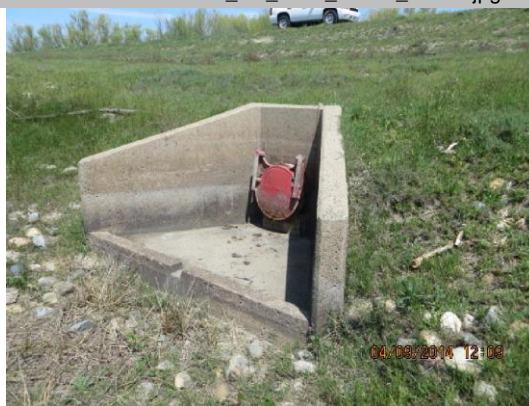
Photo 2 of 3 : UCIP_SP_2019_33707_60933.jpg

LM Start	0.85	Rating **	A/W	Issue No.	1315 (cont)
LM End	0.85	Issue Type +	Ma	Location *	
Category	Supplemental			GPS Latitude/Longitude	
				Start	End
Item	DWR UCIP LMA Responsibility			37.271894 °	37.271894 °
				-120.812224 °	-120.812224 °
DWR ID	19759				
Comment Code					
Inspector Comment					
FS_ID:33707 DS_ID:19759 EP_NO: N/A Repair Type: No Action Needed Crossing Status: Found UCIP Comments: FIELD_STRUCT_DESC: 24-inch corrugated metal gravity drainage pipe through the levee, 14.4 feet below the crown. Flap gate on the waterside (WS) end. Concrete headwall on the landside (LS) end. Concrete U-shaped headwall on the WS end. [Additional Reference(s): DWR Levee Log, 2002. USACE San Joaquin O&M Manual 601.1, 1967, (HLM 0.84)]. FS Date: 4/9/2014

Pipe, flapgate, and headwall at WS toe.

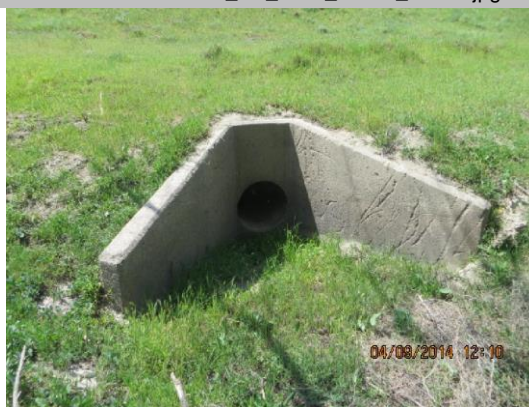
Photo 3 of 3 : UCIP_SP_2019_33707_60936.jpg

Pipe and concrete headwall at LS toe.

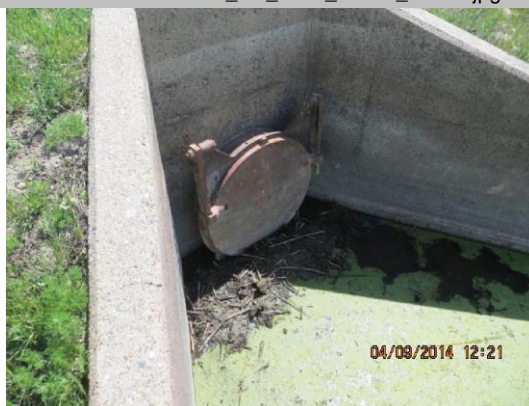
Photo 2 of 3 : UCIP_SP_2019_33708_60938.jpg

LM Start	1.45	Rating **	A/W	Issue No.	1316 (cont)	
LM End	1.45	Issue Type +	Ma	Location *		
Category	Supplemental			GPS Latitude/Longitude		
				Start	End	
Item	DWR UCIP LMA Responsibility			37.265804 °	37.265804 °	
				-120.804955 °	-120.804955 °	
DWR ID	19760					
Comment Code						
Inspector Comment						
FS_ID:33708						
DS_ID:19760						
EP_NO: N/A						
Repair Type: No Action Needed						
Crossing Status: Found						
UCIP Comments:						
FIELD_STRUCT_DESC: 36-inch corrugated metal gravity drainage pipe through the levee, 21 feet below the crown. Flap gate on the waterside (WS) end. Concrete headwall on the landside (LS) end. Concrete U-shaped headwall on the WS end. [Additional Reference(s): DWR Levee Log, 2002. USACE San Joaquin O&M Manual 601.1, 1967, (HLM 1.44)].						
FS Date: 4/9/2014

Flapgate on concrete headwall at WS toe.

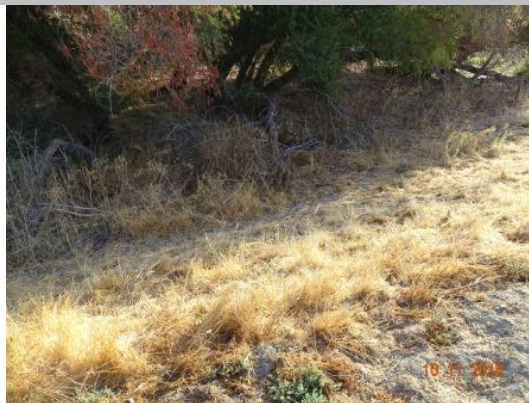
Photo 1 of 2 : SP_2019_NA0010_123_103_20190307_00012.jpg

LM Start	1.48	Rating **	M	Issue No.	103
LM End	1.48	Issue Type +	Ma	Location *	LS
Category	Earthen Levee			GPS Latitude/Longitude	
				Start	End
Item	Encroachments			37.265507 °	37.265507 °
				-120.804688 °	-120.804688 °
DWR ID	DWR_NA0010_05_s_2017_103				
Comment Code					
TR : Tree or limb					
Inspector Comment					
A fallen tree is located on the landside toe.

Fallen tree limbs at landside toe. (Fall 2018)

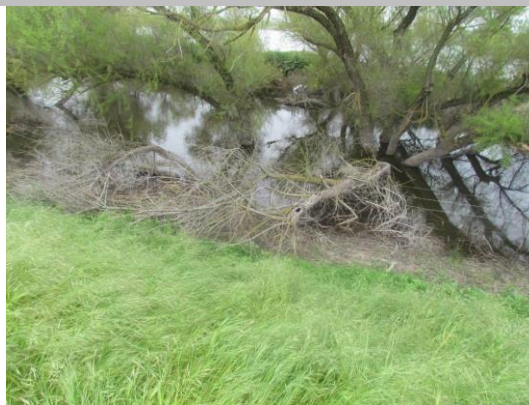
Photo 2 of 2 : SP_2019_NA0010_123_103_20190307_00013.jpg

Looking east at fallen tree at landward toe.

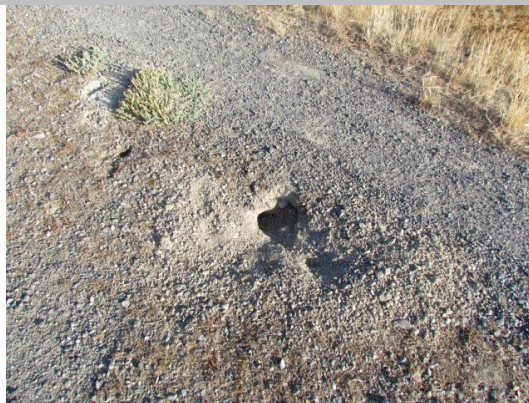
Photo 1 of 1 : SP_2019_NA0010_123_80_20190307_00011.jpg

LM Start	1.66	Rating **	M	Issue No.	80
LM End	1.75	Issue Type +	Ma	Location *	LS
Category	Earthen Levee			GPS Latitude/Longitude	
				Start	End
Item	Animal Control			37.263448 °	37.262225 °
				-120.802715 °	-120.802296 °
DWR ID	DWR_NA0010_05_f_2015_80				
Comment Code					
A3 : No rodents visible, but rodent burrows visible; need to backfill and compact or grout burrows.					
Inspector Comment					
Several rodent holes are located on levee crown and landside slope within this section.

Looking at typical view of rodent holes within this section on landward slope.

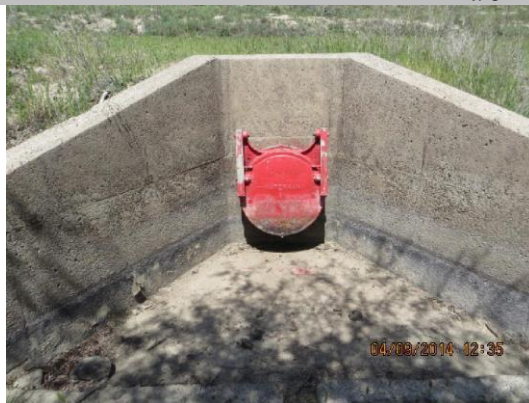
Photo 2 of 3 : UCIP_SP_2019_33709_60941.jpg

Headwall, pipe, and flapgate on WS toe.

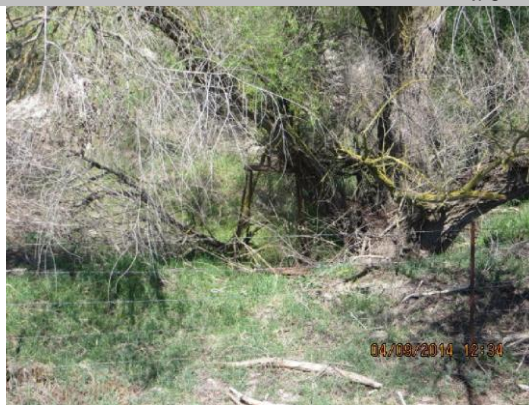
Photo 3 of 3 : UCIP_SP_2019_33709_60942.jpg

Concrete headwall and metal gate hoist on LS toe.

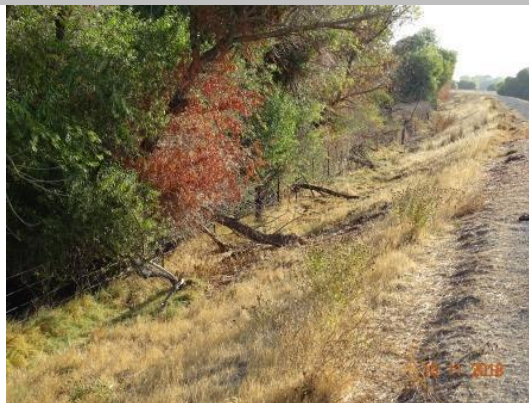
Photo 1 of 1 : SP_2019_NA0010_123_126_20190307_00027.jpg

LM Start	2.85	Rating **	M	Issue No.	126
LM End	2.85	Issue Type +	Ma	Location *	LS
Category	Earthen Levee			GPS Latitude/Longitude	
				Start	End
Item	Encroachments			37.256821 °	37.256821 °
				-120.784924 °	-120.784924 °
DWR ID	DWR_NA0010_05_f_2018_126				
Comment Code					
TR : Tree or limb					
Inspector Comment					
Several fallen tree limbs are located on the landside slope and toe.

Several tree limbs on landside slope and toe. (Fall 2018)

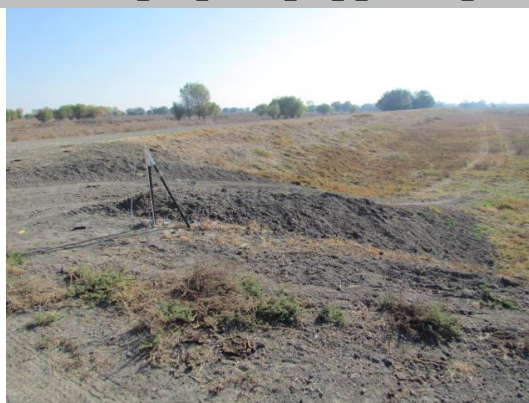
Photo 1 of 3 : SP_2019_NA0010_123_7_20190307_00003.jpg

LM Start	3.20	Rating **	M	Issue No.	7
LM End	3.20	Issue Type +	En	Location *	WS
Category	Earthen Levee			GPS Latitude/Longitude	
				Start	End
Item	Encroachments			37.256554 °	37.256554 °
				-120.778847 °	-120.778847 °
DWR ID	DWR_NA0010_05_f_2012_7				
Comment Code					
RA : Ramp					
Inspector Comment					
An unauthorized ramp is located on the waterside slope.

Looking south at unauthorized ramp on waterside slope.

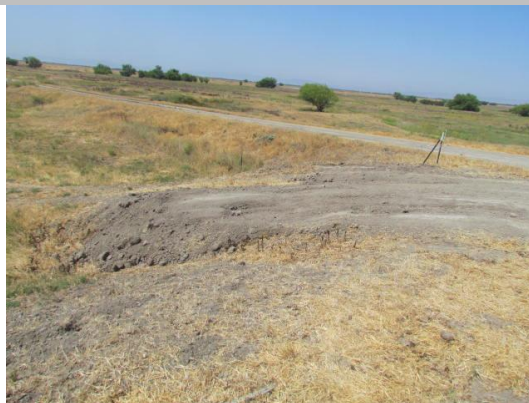
Photo 2 of 3 : SP_2019_NA0010_123_7_20190307_00004.jpg

Looking northwest at unauthorized ramp on waterward slope.

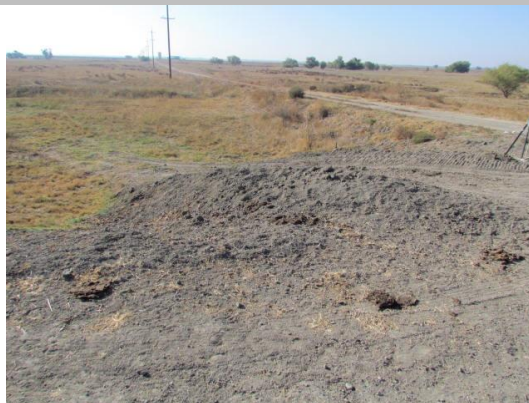
Photo 3 of 3 : SP_2019_NA0010_123_7_20190307_00005.jpg

LM Start	3.20	Rating **	M	Issue No.	7 (cont)	
LM End	3.20	Issue Type +	En	Location *	WS	
Category	Earthen Levee			GPS Latitude/Longitude		
				Start		End
Item	Encroachments			37.256554 °		37.256554 °
				-120.778847 °		-120.778847 °
DWR ID	DWR_NA0010_05_f_2012_7					
Comment Code						
RA : Ramp						
Inspector Comment						
An unauthorized ramp is located on the waterside slope.

Looking northwest at unauthorized ramp on waterside slope.

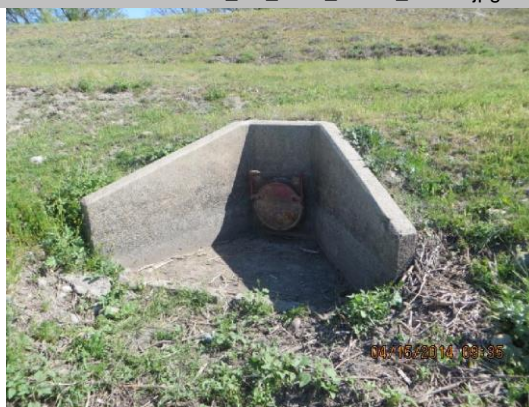
Photo 2 of 3 : UCIP_SP_2019_43055_60946.jpg

Flapgate and Concrete headwall at WS toe.

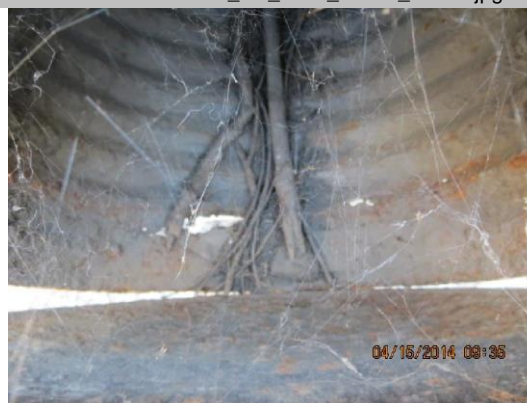
Photo 3 of 3 : UCIP_SP_2019_43055_60951.jpg

Pipe corroded through just behind flapgate at WS toe.

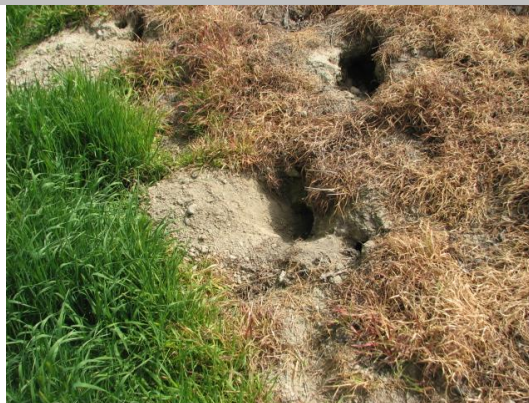
Photo 1 of 1 : SP_2019_NA0010_123_134_20190307_00034.jpg

LM Start	3.55	Rating **	M	Issue No.	134
LM End	3.55	Issue Type +	Ma	Location *	LS
Category	Earthen Levee			GPS Latitude/Longitude	
				Start	End
Item	Animal Control			37.255202 °	37.255202 °
				-120.773655 °	-120.773655 °
DWR ID	DWR_NA0010_05_f_2018_134				
Comment Code					
A3 : No rodents visible, but rodent burrows visible; need to backfill and compact or grout burrows.					
Inspector Comment					
Several rodent holes are located within this section.

Looking at typical rodent holes within this section. (Spring 2018)

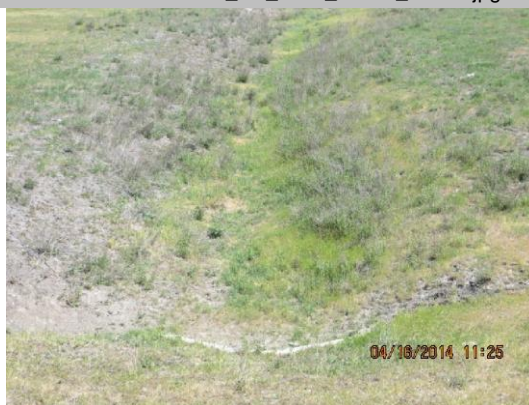
Photo 1 of 3 : UCIP_SP_2019_39586_61137.jpg

Comment Code					
Inspector Comment					
FS_ID:39586					
DS_ID:19811					
EP_NO: N/A					
Repair Type: Non-Urgent					
Crossing Status: Found					
UCIP Comments: 04/16/2014 Sediment buildup in pipe visible from landward side--recommend contacting owner to clear pipe. (DWR UCIP - W. Wylie)					
FIELD_STRUCT_DESC: 24-inch corrugated metal gravity drainage pipe through the levee, 15 feet below the crown. Flap gate on the waterside (WS) end. Concrete headwall on the landside (LS) end. Concrete U-shaped headwall on the WS end. [Additional Reference(s): DWR Levee Log, 2002. USACE San Joaquin O&M Manual 601.1, 1967, (HLM 3.67)].					
FS Date: 4/16/2014

Pipe, headwall, and flapgate on WS toe.

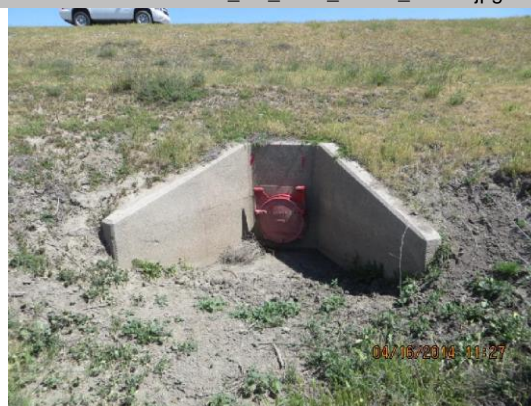
Photo 2 of 3 : UCIP_SP_2019_39586_61138.jpg

Pipe, headwall, and flapgate on WS toe.

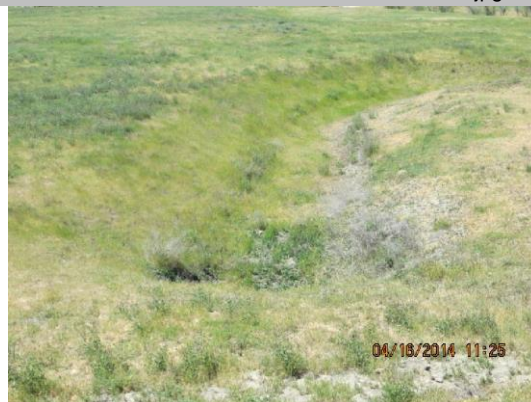
Photo 3 of 3 : UCIP_SP_2019_39586_61136.jpg

Pipe and headwall on LS toe.

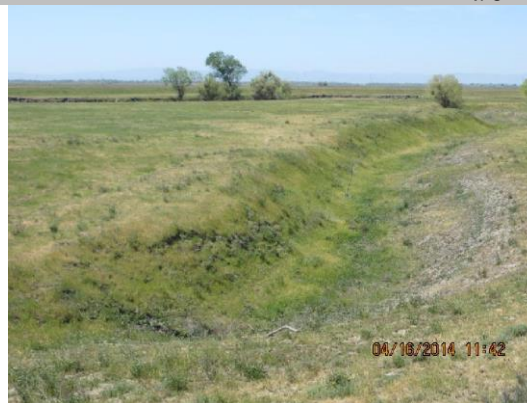
Photo 1 of 3 : UCIP_SP_2019_39880_61142.jpg

Pipe, headwall, and flapgate on WS toe.

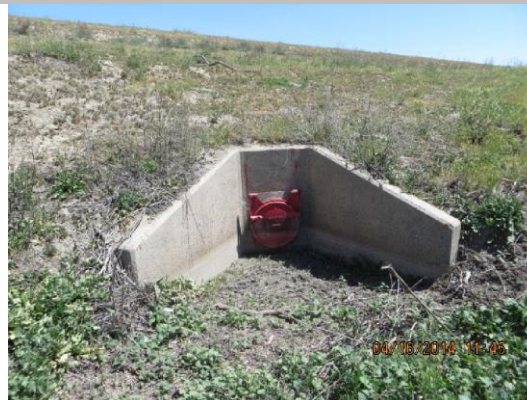
Photo 2 of 3 : UCIP_SP_2019_39880_61143.jpg

Pipe, headwall, and flapgate on WS toe.

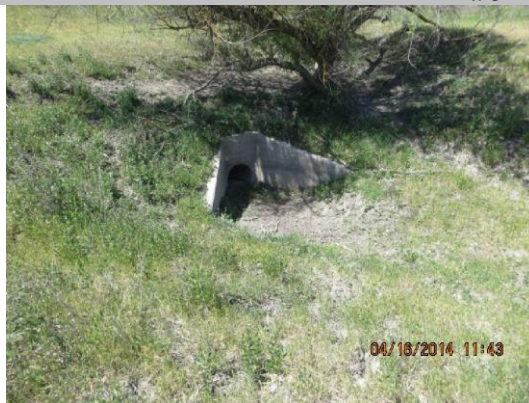
Photo 3 of 3 : UCIP_SP_2019_39880_61141.jpg

Pipe and headwall on LS toe.

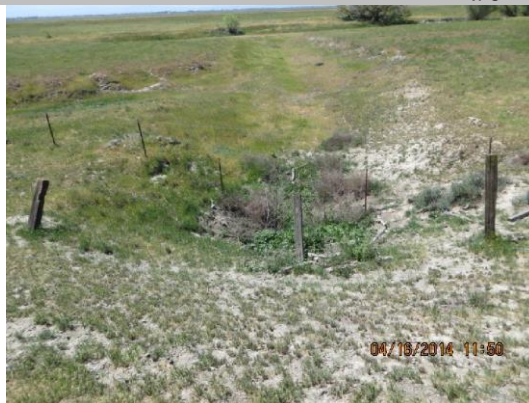
Photo 1 of 3 : UCIP_SP_2019_39588_61146.jpg

Pipe, headwall, and flapgate on WS toe.

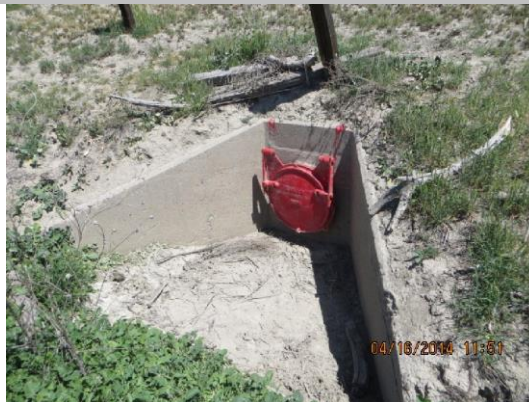
Photo 2 of 3 : UCIP_SP_2019_39588_61145.jpg

Pipe, headwall, and flapgate on WS toe.

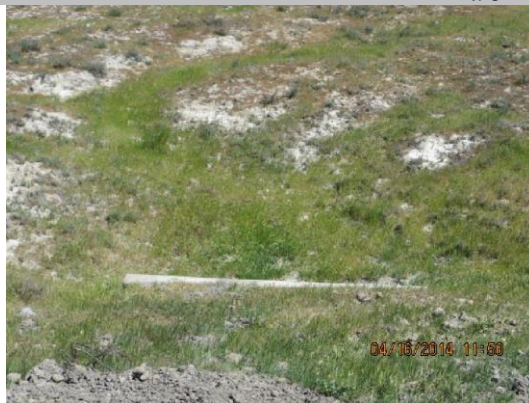
Photo 3 of 3 : UCIP_SP_2019_39588_61147.jpg

Concrete headwall and pipe on LS toe.

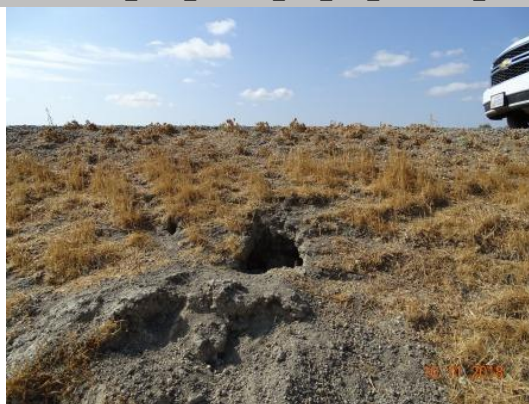
Photo 1 of 2 : SP_2019_NA0010_123_131_20190307_00030.jpg

LM Start	4.33	Rating **	U	Issue No.	131
LM End	4.33	Issue Type +	Ma	Location *	LS
Category	Earthen Levee			GPS Latitude/Longitude	
				Start	End
Item	Animal Control			37.245406 °	37.245406 °
				-120.759971 °	-120.759971 °
DWR ID	DWR_NA0010_05_f_2018_131				
Comment Code					
A3 : No rodents visible, but rodent burrows visible; need to backfill and compact or grout burrows.					
Inspector Comment					
Several large rodent holes are located on both sides of levee.

View of a large rodent hole in landward slope. (Fall 2018)

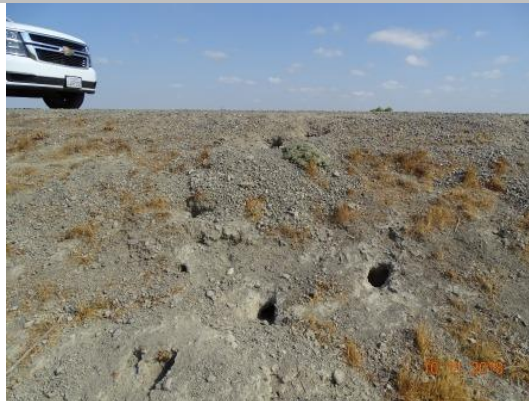
Photo 2 of 2 : SP_2019_NA0010_123_131_20190307_00031.jpg

LM Start	4.33	Rating **	U	Issue No.	131 (cont)	
LM End	4.33	Issue Type +	Ma	Location *	LS	
Category	Earthen Levee			GPS Latitude/Longitude		
				Start		End
Item	Animal Control			37.245406 °		37.245406 °
				-120.759971 °		-120.759971 °
DWR ID	DWR_NA0010_05_f_2018_131					
Comment Code						
A3 : No rodents visible, but rodent burrows visible; need to backfill and compact or grout burrows.						
Inspector Comment						
Several large rodent holes are located on both sides of levee.

View of several rodent burrows in landward slope. (Fall 2018)

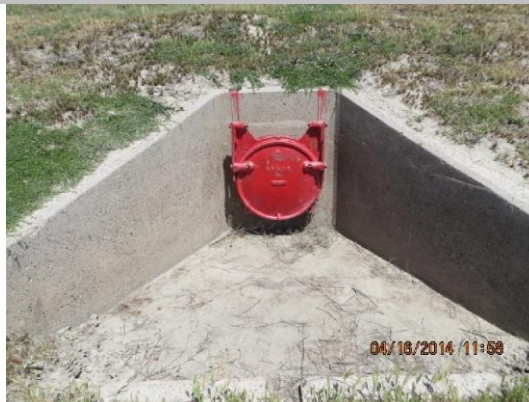
Photo 2 of 3 : UCIP_SP_2019_39589_62083.jpg

Pipe, flapgate, and headwall on WS toe.

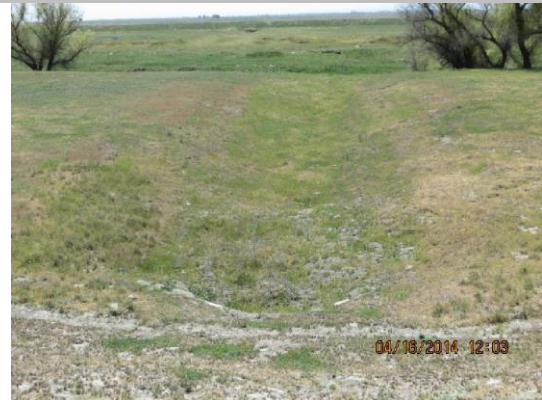
Photo 1 of 3 : UCIP_SP_2019_39590_62087.jpg

Comment Code						
Inspector Comment						
FS_ID:39590						
DS_ID:19772						
EP_NO: N/A						
Repair Type: Non-Urgent						
Crossing Status: Found						
UCIP Comments: 04/16/2014 Heavy sediment buildup in pipe visible from landward side--recommend contacting owner to clear pipe. (DWR UCIP - W. Wylie)						
FIELD_STRUCT_DESC: 24-inch corrugated metal gravity drainage pipe through the levee, 12.3 feet below the crown. Flap gate on the waterside (WS) end. Concrete headwall on the landside (LS) end. Concrete U-shaped headwall on the WS end. [Additional Reference(s): DWR Levee Log, 2002. USACE San Joaquin O&M Manual 601.1, 1967, (HLM 4.89)].						
FS Date: 4/16/2014

Headwall, flapgate, and pipe on WS toe.

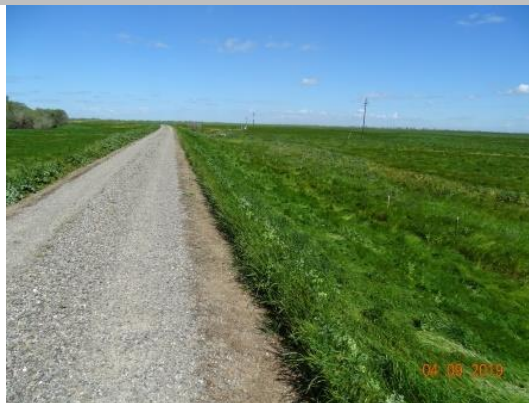
Photo 1 of 1 : SP_2019_NA0010_123_122_20190422_00335.jpg

LM Start	5.12	Rating **	U	Issue No.	122
LM End	8.09	Issue Type +	Ma	Location *	LS
Category	Earthen Levee			GPS Latitude/Longitude	
				Start	End
Item	Vegetation			37.240628 °	37.213556 °
				-120.747510 °	-120.706519 °
DWR ID	DWR_NA0010_05_s_2019_122				
Comment Code					
V1 : Control annual grass and weeds on the levee slopes and easements.					
Inspector Comment

View of landside slope looking downstream. (Spring 2019)

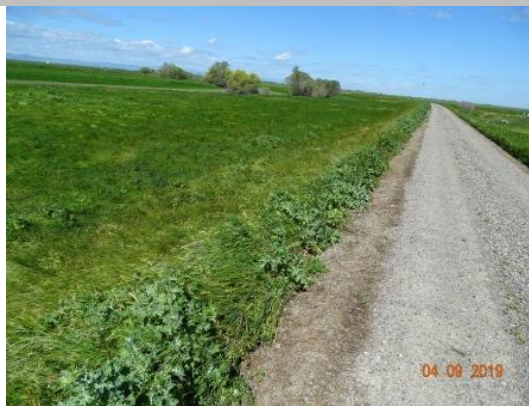
Photo 1 of 1 : SP_2019_NA0010_123_136_20190422_00336.jpg

LM Start	5.12	Rating **	U	Issue No.	136
LM End	8.09	Issue Type +	Ma	Location *	WS
Category	Earthen Levee			GPS Latitude/Longitude	
				Start	End
Item	Vegetation			37.240628 °	37.213556 °
				-120.747503 °	-120.706519 °
DWR ID	DWR_NA0010_05_s_2019_136				
Comment Code					
V1 : Control annual grass and weeds on the levee slopes and easements.					
Inspector Comment

View of waterside slope looking downstream. (Spring 2019)

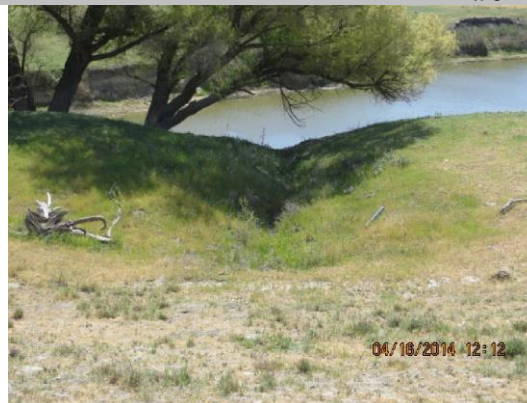
Photo 1 of 3 : UCIP_SP_2019_39591_62091.jpg

LM Start	5.15	Rating **	M	Issue No.	1324	
LM End	5.15	Issue Type +	Ma	Location *		
Category	Supplemental			GPS Latitude/Longitude		
				Start		End
Item	DWR UCIP LMA Responsibility			37.240607 °		37.240607 °
				-120.746916 °		-120.746916 °
DWR ID	19773					
Comment Code						
Inspector Comment						
FS_ID:39591 DS_ID:19773 EP_NO: N/A Repair Type: Non-Urgent Crossing Status: Found UCIP Comments: 04/16/2014 Heavy sediment buildup in pipe visible through the levee, 12.2 feet below the crown. Flap gate on the waterside (WS) end. Concrete headwall on the landside (LS) end. Concrete U-shaped headwall on the WS end. [Additional Reference(s): DWR Levee Log, 2002. USACE San Joaquin O&M Manual 601.1, 1967, (HLM 5.15)]. FS Date: 4/16/2014

Headwall, flapgate, and pipe on WS toe.

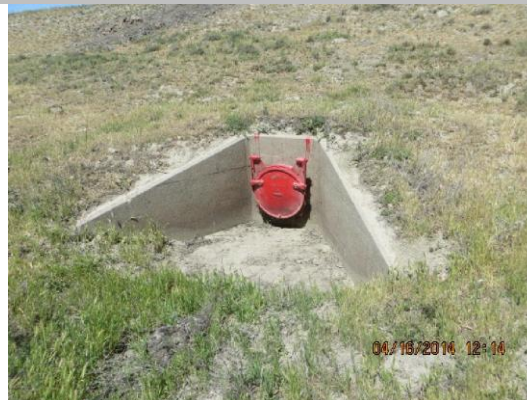
Photo 2 of 3 : UCIP_SP_2019_39591_62093.jpg

Headwall, flapgate, and pipe on WS toe.
