**Flood Control Project Maintenance
Levee Inspections**
LMA District Cover Sheet
Spring 2019 Levee Inspection Results

Lower San Joaquin Levee District

Spring 2019 Levee Inspection Results

Waterway			Bank	Unit Miles
Unit No. 01 San Joaquin River			Right	22.52
	Spring (March - May)	Summer (June - August)	(September - November) Fall	Winter (December - February)
Unit Maintenance Rating (Fall Only)				
Date of Inspection	3/26/2019 - 3/26/2019			
DWR Inspector	Corey Fujitani			
Accompanied By

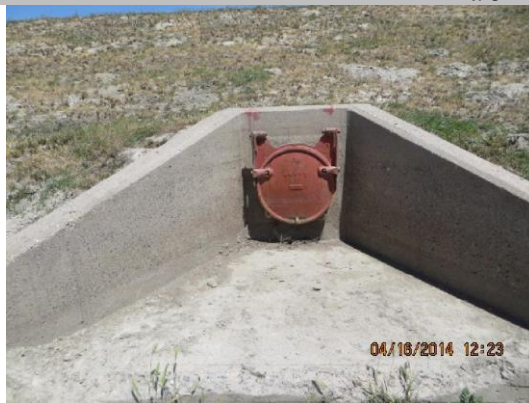
Photo 2 of 3 : UCIP_SP_2019_34151_62095.jpg

LM Start	5.58	Rating **	A/W	Issue No.	1325 (cont)	
LM End	5.58	Issue Type +	Ma	Location *		
Category	Supplemental			GPS Latitude/Longitude		
				Start	End	
Item	DWR UCIP LMA Responsibility			37.238879 °	37.238879 °	
				-120.739719 °	-120.739719 °	
DWR ID	19774					
Comment Code						
Inspector Comment						
FS_ID:34151 DS_ID:19774 EP_NO: N/A Repair Type: No Action Needed Crossing Status: Found UCIP Comments: FIELD_STRUCT_DESC: 24-inch corrugated metal gravity drainage pipe through the levee, 9.5 feet below the crown. Flap gate on the waterside (WS) end. Concrete headwall on the landside (LS) end. Concrete U-shaped headwall on the WS end. [Additional Reference(s): DWR Levee Log, 2002. USACE San Joaquin O&M Manual 601.1, 1967, (HLM 5.58)]. FS Date: 4/16/2014

Headwall, flapgate, and pipe on WS toe.

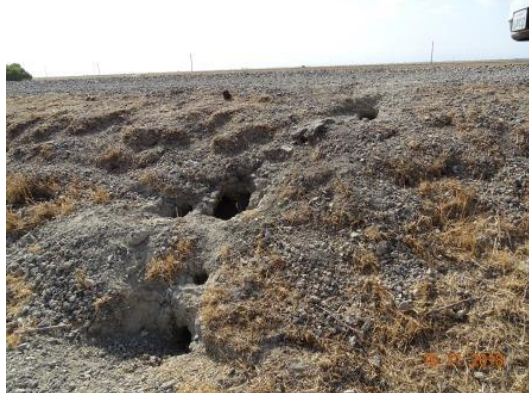
Photo 1 of 2 : SP_2019_NA0010_123_138_20190307_00036.jpg

LM Start	5.94	Rating **	U	Issue No.	138
LM End	5.94	Issue Type +	Ma	Location *	LS
Category	Earthen Levee			GPS Latitude/Longitude	
				Start	End
Item	Animal Control			37.236387 °	37.236387 °
				-120.734164 °	-120.734164 °
DWR ID	DWR_NA0010_05_f_2018_138				
Comment Code					
A1 : Exterminate rodents and backfill and compact or grout burrows.					
Inspector Comment					
Several large rodent holes are located at this location.

View of large rodent holes in landside slope. (Fall 2018)

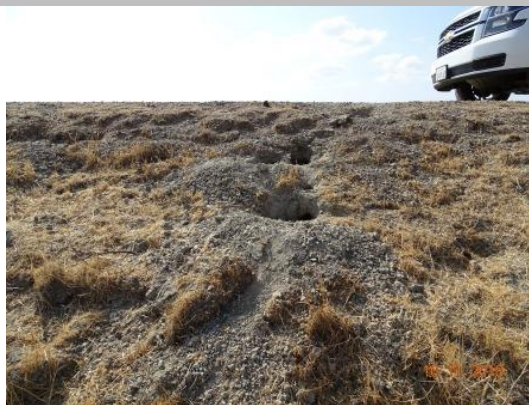
Photo 2 of 2 : SP_2019_NA0010_123_138_20190307_00037.jpg

View of large rodent holes in landside slope. (Fall 2018)

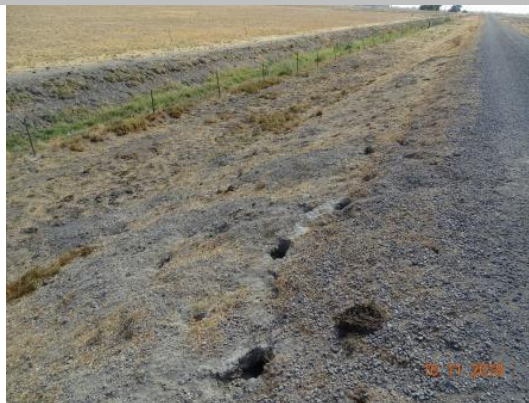
Photo 1 of 2 : SP_2019_NA0010_123_139_20190307_00038.jpg

LM Start	6.40	Rating **	M	Issue No.	139
LM End	6.40	Issue Type +	Ma	Location *	LS
Category	Earthen Levee			GPS Latitude/Longitude	
				Start	End
Item	Animal Control			37.231900 °	37.231900 °
				-120.728345 °	-120.728345 °
DWR ID	DWR_NA0010_05_f_2018_139				
Comment Code					
A1 : Exterminate rodents and backfill and compact or grout burrows.					
Inspector Comment

View of rodent holes on landside shoulder. (Fall 2018)

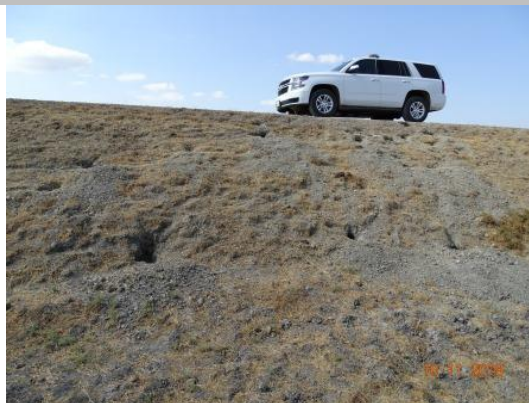
Photo 2 of 2 : SP_2019_NA0010_123_139_20190307_00039.jpg

LM Start	6.40	Rating **	M	Issue No.	139 (cont)	
LM End	6.40	Issue Type +	Ma	Location *	LS	
Category	Earthen Levee			GPS Latitude/Longitude		
				Start		End
Item	Animal Control			37.231900 °		37.231900 °
				-120.728345 °		-120.728345 °
DWR ID	DWR_NA0010_05_f_2018_139					
Comment Code						
A1 : Exterminate rodents and backfill and compact or grout burrows.						
Inspector Comment

View of rodent holes on landside slope. (Fall 2018)

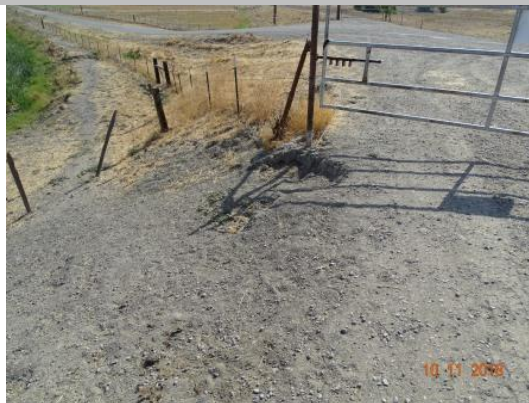
Photo 1 of 1 : SP_2019_NA0010_123_140_20190307_00040.jpg

LM Start	6.56	Rating **	M	Issue No.	140
LM End	6.56	Issue Type +	Ma	Location *	LS
Category	Earthen Levee			GPS Latitude/Longitude	
				Start	End
Item	Slope Stability			37.230013 °	37.230013 °
				-120.726832 °	-120.726832 °
DWR ID	DWR_NA0010_05_f_2018_140				
Comment Code					
S2 : Repair the levee slope damaged by foot traffic and prevent access where possible.					
Inspector Comment					
There is erosion on the landward slope near the gate.

Erosion on landward slope caused by foot traffic. (Fall 2018)

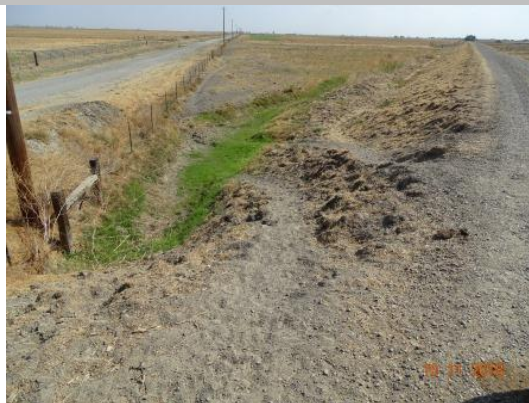
Photo 1 of 3 : SP_2019_NA0010_123_1309_20190307_00064.jpg

LM Start	6.59	Rating **	M	Issue No.	1309
LM End	6.59	Issue Type +	Ma	Location *	LS
Category	Earthen Levee			GPS Latitude/Longitude	
				Start	End
Item	Slope Stability			37.229682 °	37.229682 °
				-120.726305 °	-120.726305 °
DWR ID	DWR_NA0010_05_s_2015_1309				
Comment Code					
S2 : Repair the levee slope damaged by foot traffic and prevent access where possible.					
Inspector Comment					
The landside slope has damage caused by animal foot traffic.

Looking upstream at damaged landside slope. (Fall 2018)

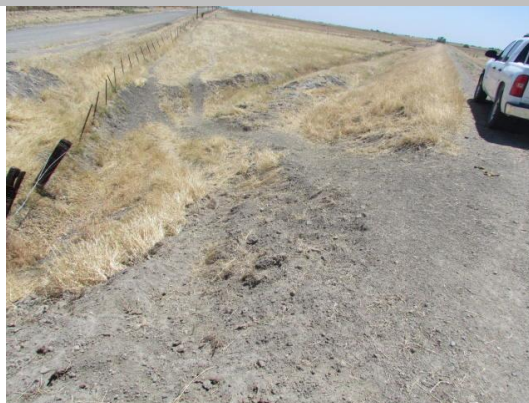
Photo 3 of 3 : SP_2019_NA0010_123_1309_20190307_00066.jpg

Looking east at damaged landward slope.

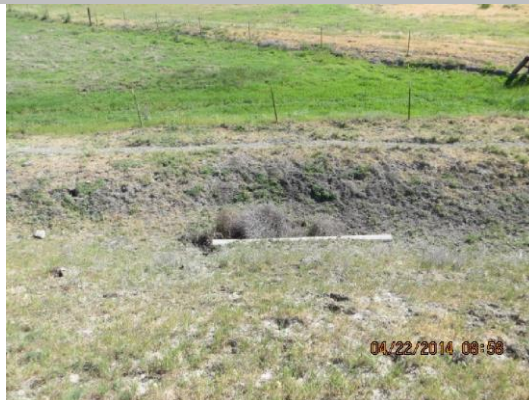
Photo 3 of 3 : UCIP_SP_2019_39592_62112.jpg

Headwall and pipe on LS toe.

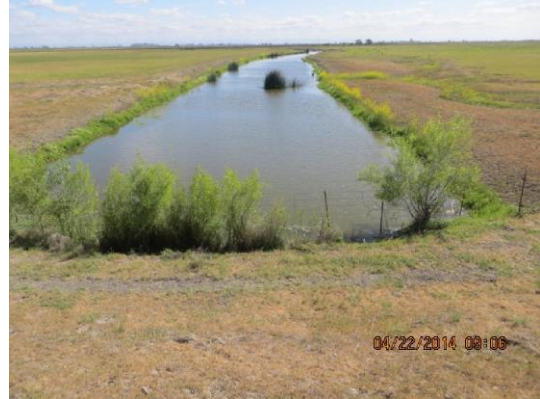
Photo 1 of 2 : UCIP_SP_2019_34170_62116.jpg

Comment Code						
Inspector Comment						
FS_ID:34170						
DS_ID:19762						
EP_NO: N/A						
Repair Type: Non-Urgent						
Crossing Status: Indicator Found						
UCIP Comments: 04/22/2014 Appears abandoned and if so should be done so properly. Slide gate rusted shut on WS slope. Unable to locate inlet or outlet. (DWR UCIP - W. Wylie)						
FIELD_STRUCT_DESC: 24-inch corrugated metal gravity drainage pipe through the levee, 20.4 feet below the crown. Slide gate in 36-inch corrugated metal pipe (CMP) riser on the waterside (WS) slope. Concrete U-shaped headwall on each end. Not found in 2014.						
[Additional Reference(s): DWR Levee Log, 2002. USACE San Joaquin O&M Manual 601.1, 1967, (HLM 7.58)].						
FS Date: 4/22/2014

Likely inlet on LS toe. No pipe or headwall can be seen at current water level.

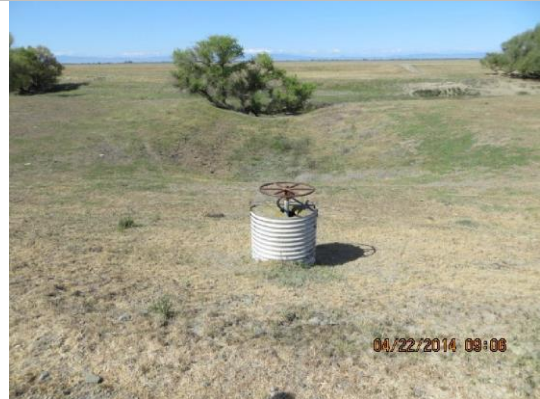
Photo 2 of 2 : UCIP_SP_2019_34170_62115.jpg

Slide gate in CMP riser on WS slope. No outlet or pipe found on WS toe.

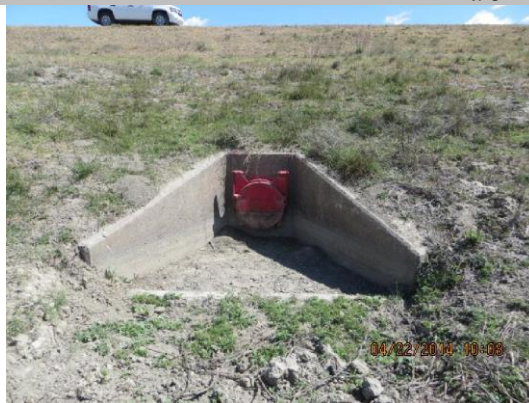
Photo 2 of 3 : UCIP_SP_2019_34265_62183.jpg

LM Start	8.46	Rating **	M	Issue No.	1330 (cont)	
LM End	8.46	Issue Type +	Ma	Location *		
Category	Supplemental			GPS Latitude/Longitude		
				Start	End	
Item	DWR UCIP LMA Responsibility			37.209606 °	37.209606 °	
				-120.702069 °	-120.702069 °	
DWR ID	19763					
Comment Code						
Inspector Comment						
FS_ID:34265 DS_ID:19763 EP_NO: N/A Repair Type: Non-Urgent Crossing Status: Found UCIP Comments: 04/22/2014 Pipe filled with silt on LS toe and should be cleared. (DWR UCIP - W. Wylie) FIELD_STRUCT_DESC: 24-inch corrugated metal gravity drainage pipe through the levee, 16 feet below the crown. Flap gate on the waterside (WS) end. Concrete headwall on the landside (LS) end. Concrete U-shaped headwall on the WS end. [Additional Reference(s): DWR Levee Log, 2002. USACE San Joaquin O&M Manual 601.1, 1967, (HLM 8.44)]. FS Date: 4/22/2014

Headwall, flapgate, and pipe on WS toe

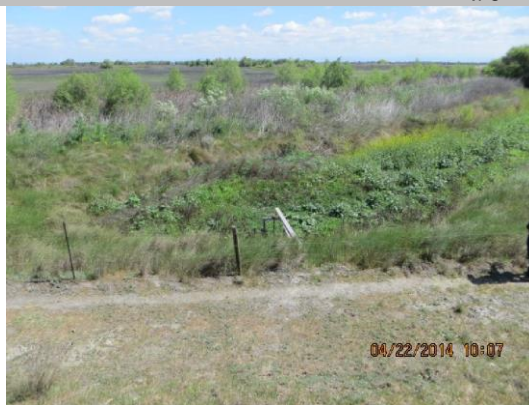
Photo 3 of 3 : UCIP_SP_2019_34265_62181.jpg

Headwall, slidegate, and pipe on LS toe.

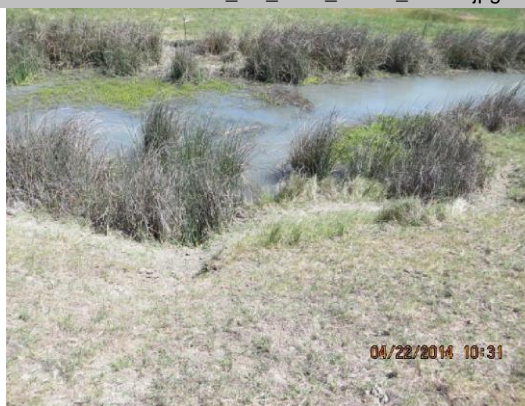
Photo 3 of 3 : UCIP_SP_2019_34272_62197.jpg

LM Start	9.28	Rating **	A/W	Issue No.	1331 (cont)	
LM End	9.28	Issue Type +	Ma	Location *		
Category	Supplemental			GPS Latitude/Longitude		
				Start		End
Item	DWR UCIP LMA Responsibility			37.202742 °		37.202742 °
				-120.690064 °		-120.690064 °
DWR ID	19766					
Comment Code						
Inspector Comment						
FS_ID:34272						
DS_ID:19766						
EP_NO: N/A						
Repair Type: No Action Needed						
Crossing Status: Found						
UCIP Comments:						
FIELD_STRUCT_DESC: 36-inch corrugated metal gravity drainage pipe						
through the levee, 14.8 feet below the crown. Slide gate in a 48-inch						
corrugated metal pipe (CMP) riser on the waterside (WS) slope.						
Concrete headwall on each end. [Additional Reference(s): DWR Levee						
Log, 2002. USACE San Joaquin O&M Manual 601.1, 1967, (HLM 9.26)].						
FS Date: 4/22/2014

Headwall and pipe at LS toe.

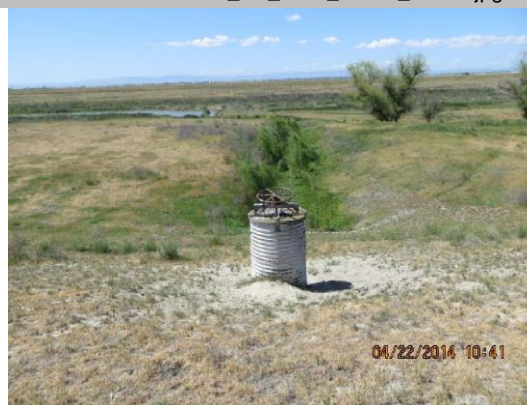
Photo 1 of 3 : UCIP_SP_2019_34273_62201.jpg

LM Start	10.06	Rating **	M	Issue No.	1332
LM End	10.06	Issue Type +	Ma	Location *	
Category	Supplemental			GPS Latitude/Longitude	
				Start	End
Item	DWR UCIP LMA Responsibility			37.194736 °	37.194736 °
				-120.680116 °	-120.680116 °
DWR ID	19767				
Comment Code					
Inspector Comment					
FS_ID:34273 DS_ID:19767 EP_NO: N/A Repair Type: Non-Urgent Crossing Status: Found UCIP Comments: 04/22/2014 Slidegate actuator appears bent and may not work properly (WS slope). (DWR UCIP - W. Wylie) FIELD_STRUCT_DESC: 24-inch corrugated metal gravity drainage pipe through the levee, 15 feet below the crown. Slide gate in a 36-inch corrugated metal pipe (CMP) riser on the waterside (WS) slope. Concrete headwall on each end. [Additional Reference(s): DWR Levee Log, 2002. USACE San Joaquin O&M Manual 601.1, 1967, (HLM 10.05)]. FS Date: 4/22/2014

Slidegate in CMP riser on WS slope.

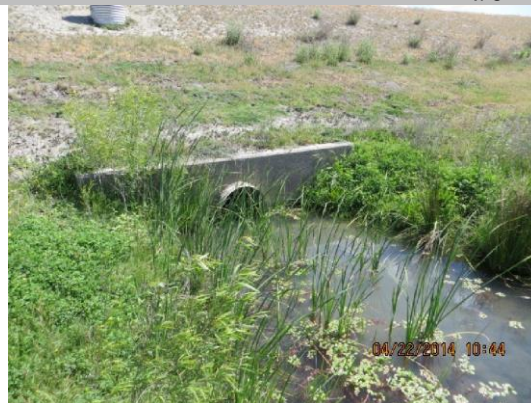
Photo 2 of 3 : UCIP_SP_2019_34273_62202.jpg

LM Start	10.06	Rating **	M	Issue No.	1332 (cont)
LM End	10.06	Issue Type +	Ma	Location *	
Category	Supplemental			GPS Latitude/Longitude	
				Start	End
Item	DWR UCIP LMA Responsibility			37.194736 °	37.194736 °
				-120.680116 °	-120.680116 °
DWR ID	19767				
Comment Code					
Inspector Comment					
FS_ID:34273 DS_ID:19767 EP_NO: N/A Repair Type: Non-Urgent Crossing Status: Found UCIP Comments: 04/22/2014 Slidegate actuator appears bent and may not work properly (WS slope). (DWR UCIP - W. Wylie) FIELD_STRUCT_DESC: 24-inch corrugated metal gravity drainage pipe through the levee, 15 feet below the crown. Slide gate in a 36-inch corrugated metal pipe (CMP) riser on the waterside (WS) slope. Concrete headwall on each end. [Additional Reference(s): DWR Levee Log, 2002. USACE San Joaquin O&M Manual 601.1, 1967, (HLM 10.05)]. FS Date: 4/22/2014

Concrete headwall and pipe on WS toe.

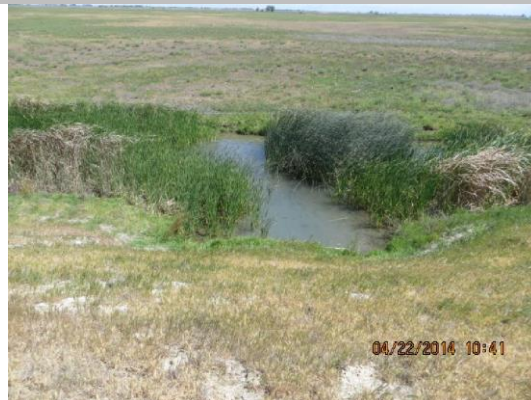
Photo 3 of 3 : UCIP_SP_2019_34273_62200.jpg

Concrete headwall and pipe on LS toe.

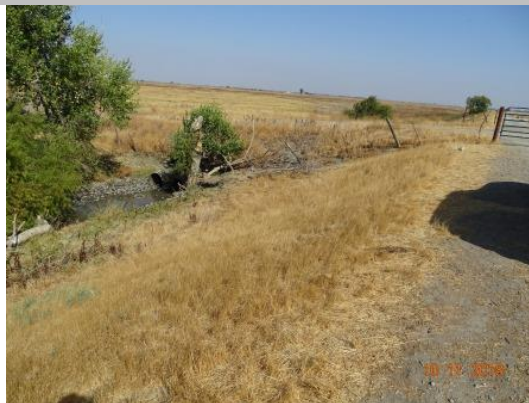
Photo 1 of 1 : SP_2019_NA0010_123_142_20190307_00041.jpg

LM Start	10.66	Rating **	M	Issue No.	142
LM End	10.66	Issue Type +	Ma	Location *	LS
Category	Earthen Levee			GPS Latitude/Longitude	
				Start	End
Item	Encroachments			37.190286 °	37.190286 °
				-120.671207 °	-120.671207 °
DWR ID	DWR_NA0010_05_f_2018_142				
Comment Code					
TR : Tree or limb					
Inspector Comment					
A fallen tree is located on the landside toe and slope.

Fallen tree on landside toe and slope. (Fall 2018)

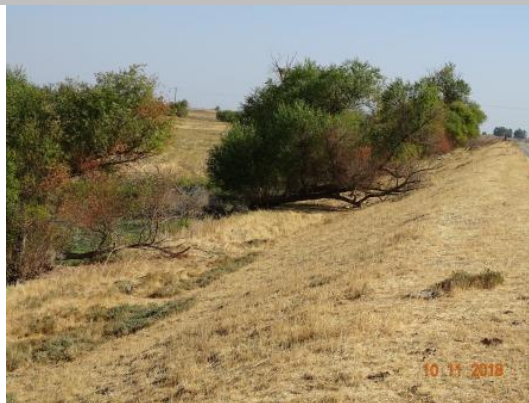
Photo 1 of 1 : SP_2019_NA0010_123_144_20190307_00042.jpg

LM Start	11.37	Rating **	M	Issue No.	144
LM End	11.37	Issue Type +	Ma	Location *	LS
Category	Earthen Levee			GPS Latitude/Longitude	
				Start	End
Item	Trim / Thin Trees			37.187792 °	37.187792 °
				-120.659454 °	-120.659454 °
DWR ID	DWR_NA0010_05_f_2018_144				
Comment Code					
T2 : Thin trees to allow visibility of the ground and room to flood fight.					
Inspector Comment					
Tree limbs on the levee slope should be trimmed to allow access.

View of tree limbs on levee slope. (Fall 2018)

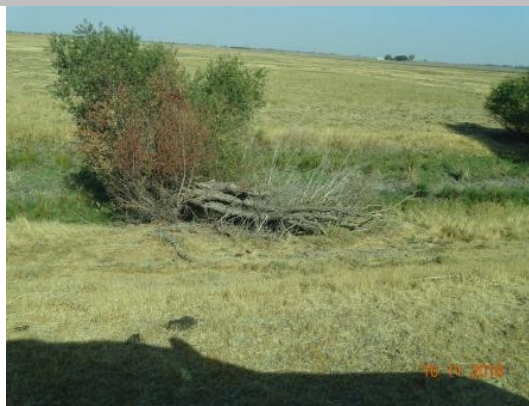
Photo 1 of 1 : SP_2019_NA0010_123_145_20190307_00043.jpg

LM Start	11.41	Rating **	M	Issue No.	145
LM End	11.41	Issue Type +	Ma	Location *	LS
Category	Earthen Levee			GPS Latitude/Longitude	
				Start	End
Item	Trim / Thin Trees			37.187404 °	37.187404 °
				-120.659005 °	-120.659005 °
DWR ID	DWR_NA0010_05_f_2018_145				
Comment Code					
T2 : Thin trees to allow visibility of the ground and room to flood fight.					
Inspector Comment					
A fallen tree trunk is located on the levee toe.

Fallen tree on levee toe. (Fall 2018)

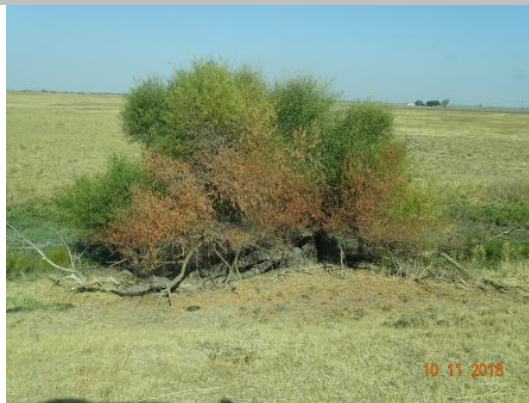
Photo 1 of 1 : SP_2019_NA0010_123_146_20190307_00044.jpg

LM Start	11.44	Rating **	M	Issue No.	146
LM End	11.44	Issue Type +	Ma	Location *	LS
Category	Earthen Levee			GPS Latitude/Longitude	
				Start	End
Item	Trim / Thin Trees			37.187021 °	37.187021 °
				-120.658564 °	-120.658564 °
DWR ID	DWR_NA0010_05_f_2018_146				
Comment Code					
T2 : Thin trees to allow visibility of the ground and room to flood fight.					
Inspector Comment					
Fallen tree limbs are located on the levee toe.

Tree limbs and trunk on levee toe. (Fall 2018)

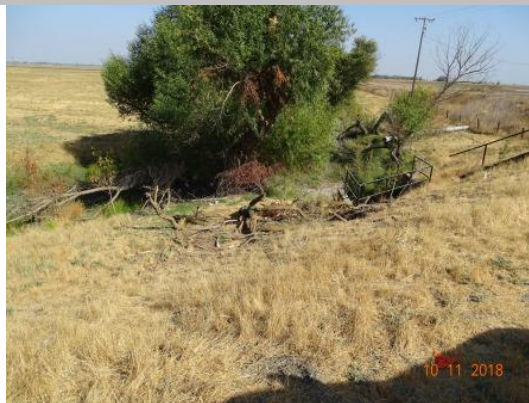
Photo 1 of 1 : SP_2019_NA0010_123_147_20190307_00045.jpg

LM Start	11.49	Rating **	M	Issue No.	147
LM End	11.49	Issue Type +	En	Location *	LS
Category	Earthen Levee			GPS Latitude/Longitude	
				Start	End
Item	Encroachments			37.186482 °	37.186482 °
				-120.657935 °	-120.657935 °
DWR ID	DWR_NA0010_05_f_2018_147				
Comment Code					
TR : Tree or limb					
Inspector Comment					
Tree limbs are located on landside slope and toe.

Tree limbs on levee toe. (Fall 2018)

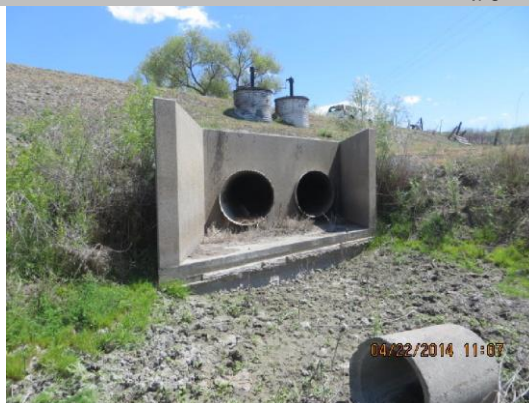
Photo 1 of 3 : UCIP_SP_2019_34281_62219.jpg

LM Start	11.49	Rating **	A/W	Issue No.	1333
LM End	11.49	Issue Type +	Ma	Location *	
Category	Supplemental			GPS Latitude/Longitude	
				Start	End
Item	DWR UCIP LMA Responsibility			37.186471 °	37.186471 °
				-120.657915 °	-120.657915 °
DWR ID	19768				
Comment Code					
Inspector Comment					
FS_ID:34281 DS_ID:19768 EP_NO: N/A Repair Type: No Action Needed Crossing Status: Found UCIP Comments: FIELD_STRUCT_DESC: [Deadman Drainage Structure] 1 of 2: 48-inch corrugated metal gravity drainage pipe through the levee, 16 feet below the crown. Slide gate in a 60-inch corrugated metal pipe (CMP) riser on the waterside (WS) slope. Concrete U-shaped headwall on each end. Stairs on the landside (LS) slope. [Additional Reference(s): DWR Levee Log, 2002. USACE San Joaquin O&M Manual 601.1, 1967, (HLM 11.48)]. FS Date: 4/22/2014

Slidegate in CMP riser, concrete headwall and pipe visible on WS slope.

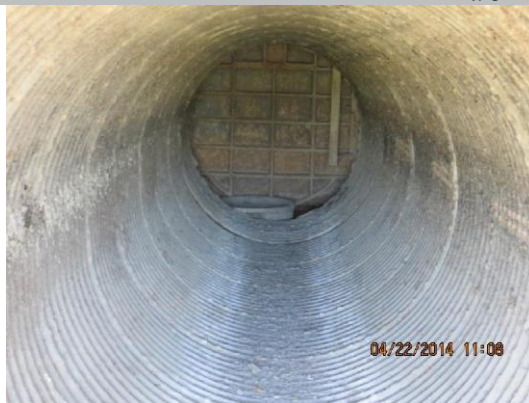
Photo 3 of 3 : UCIP_SP_2019_34280_62215.jpg

LM Start	11.50	Rating **	A/W	Issue No.	1334 (cont)
LM End	11.50	Issue Type +	Ma	Location *	
Category	Supplemental			GPS Latitude/Longitude	
				Start	End
Item	DWR UCIP LMA Responsibility			37.186458 °	37.186458 °
				-120.657903 °	-120.657903 °
DWR ID	19734				
Comment Code					
Inspector Comment					
FS_ID:34280 DS_ID:19734 EP_NO: N/A Repair Type: No Action Needed Crossing Status: Found UCIP Comments: FIELD_STRUCT_DESC: [Deadman Drainage Structure] 2 of 2: 48-inch corrugated metal gravity drainage pipe through the levee, 16 feet below the crown. Slide gate in a 60-inch corrugated metal pipe (CMP) riser on the waterside (WS) slope. Concrete U-shaped headwall on each end. Stairs on the landside (LS) slope. [Additional Reference(s): DWR Levee Log, 2002. USACE San Joaquin O&M Manual 601.1, 1967, (HLM 11.48)]. FS Date: 4/22/2014

Inside pipe on WS toe.

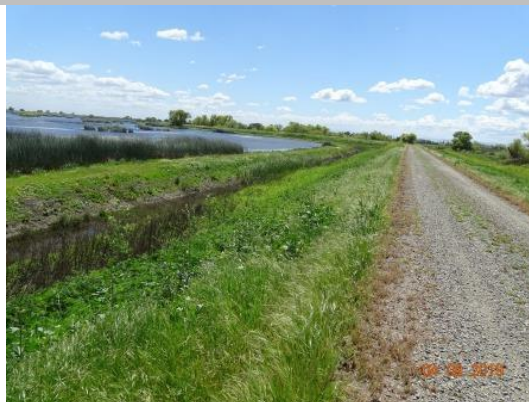
Photo 1 of 1 : SP_2019_NA0010_123_179_20190423_00338.jpg

LM Start	11.55	Rating **	U	Issue No.	179
LM End	14.35	Issue Type +	Ma	Location *	LS
Category	Earthen Levee			GPS Latitude/Longitude	
				Start	End
Item	Vegetation			37.185829 °	37.163394 °
				-120.657181 °	-120.620270 °
DWR ID	DWR_NA0010_05_s_2019_179				
Comment Code					
V1 : Control annual grass and weeds on the levee slopes and easements.					
Inspector Comment

View of landside slope looking upstream. (Spring 2019)

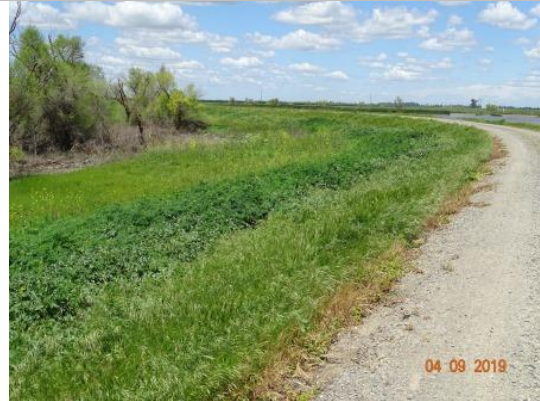
Photo 1 of 1 : SP_2019_NA0010_123_180_20190423_00337.jpg

LM Start	11.55	Rating **	U	Issue No.	180
LM End	14.35	Issue Type +	Ma	Location *	WS
Category	Earthen Levee			GPS Latitude/Longitude	
				Start	End
Item	Vegetation			37.185829 °	37.163394 °
				-120.657181 °	-120.620270 °
DWR ID	DWR_NA0010_05_s_2019_180				
Comment Code					
V1 : Control annual grass and weeds on the levee slopes and easements.					
Inspector Comment

View of waterside slope looking downstream. (Spring 2019)

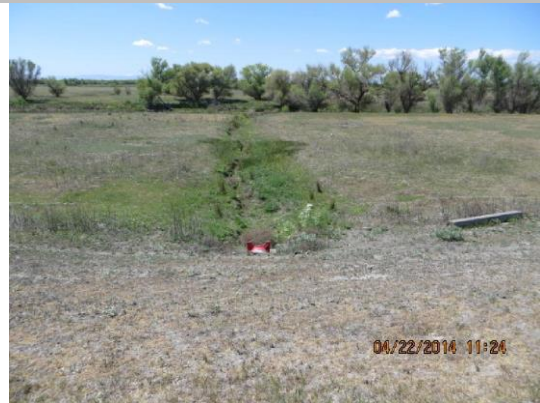
Photo 1 of 3 : UCIP_SP_2019_34283_62221.jpg

LM Start	11.65	Rating **	A/W	Issue No.	1335
LM End	11.65	Issue Type +	Ma	Location *	
Category	Supplemental			GPS Latitude/Longitude	
				Start	End
Item	DWR UCIP LMA Responsibility			37.184830 °	37.184830 °
				-120.656016 °	-120.656016 °
DWR ID	19704				
Comment Code					
Inspector Comment					
FS_ID:34283					
DS_ID:19704					
EP_NO: N/A					
Repair Type: No Action Needed					
Crossing Status: Found					
UCIP Comments:					
FIELD_STRUCT_DESC: 24-inch corrugated metal gravity drainage pipe through the levee, 11.8 feet below the crown. Flap gate on the waterside (WS) end. Concrete headwall on the landside (LS) end. Concrete saddle and apron on the WS end. [Additional Reference(s): DWR Levee Log, 2002. USACE San Joaquin O&M Manual 601.1, 1967, (HLM 11.63)].					
FS Date: 4/22/2014

Headwall, flapgate, and pipe at WS toe.

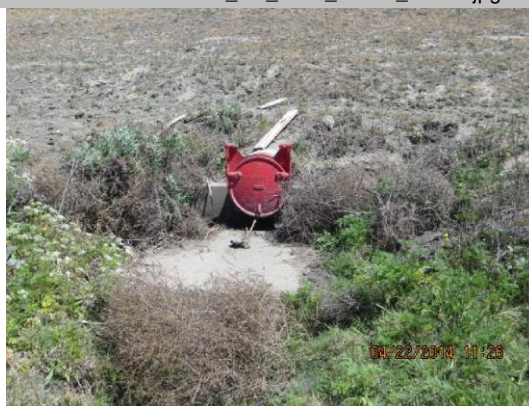
Photo 2 of 3 : UCIP_SP_2019_34283_62223.jpg

Headwall, flapgate, and pipe at WS toe.

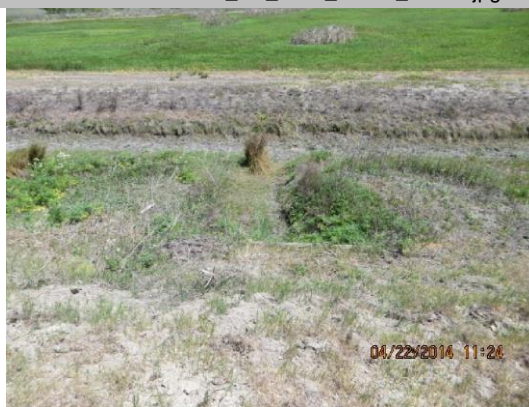
Photo 3 of 3 : UCIP_SP_2019_34283_62222.jpg

Concrete headwall and pipe at LS toe.

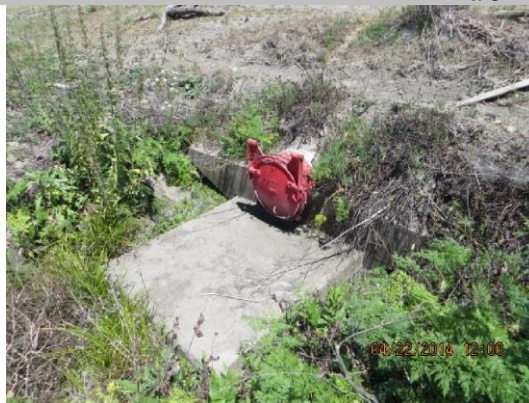
Photo 2 of 3 : UCIP_SP_2019_34284_62227.jpg

Headwall, flapgate, and pipe on WS toe.

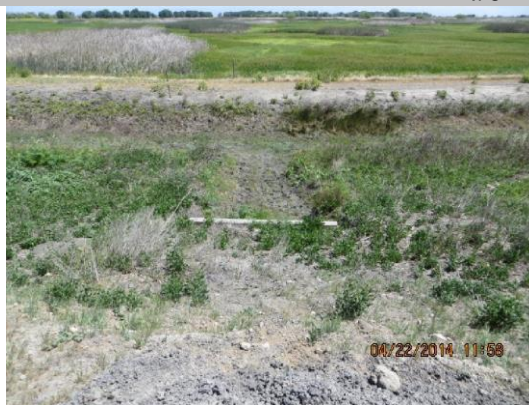
Photo 3 of 3 : UCIP_SP_2019_34284_62226.jpg

Headwall and pipe on LS toe.

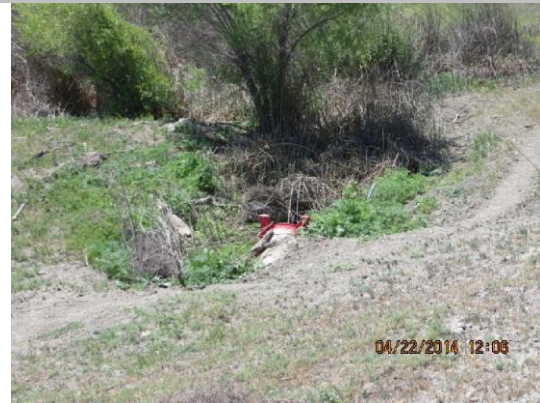
Photo 1 of 3 : UCIP_SP_2019_34285_62230.jpg

LM Start	12.40	Rating **	A/W	Issue No.	1337
LM End	12.40	Issue Type +	Ma	Location *	
Category	Supplemental			GPS Latitude/Longitude	
				Start	End
Item	DWR UCIP LMA Responsibility			37.175958 °	37.175958 °
				-120.649798 °	-120.649798 °
DWR ID	19706				
Comment Code					
Inspector Comment					
FS_ID:34285 DS_ID:19706 EP_NO: N/A Repair Type: No Action Needed Crossing Status: Found UCIP Comments: FIELD_STRUCT_DESC: 24-inch corrugated metal gravity drainage pipe through the levee, 10.2 feet below the crown. Flap gate on the waterside (WS) end. Concrete headwall on the landside (LS) end. Concrete saddle and apron on the WS end. Flashboard attachment on the LS end. Pipe crosses levee at 45 degrees to crown alignment. [Additional Reference(s): DWR Levee Log, 2002. USACE San Joaquin O&M Manual 601.1, 1967, (HLM 12.38)]. FS Date: 4/22/2014

Headwall, flapgate, and pipe on WS toe.

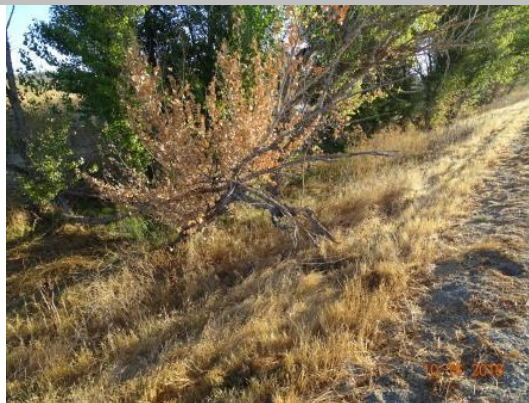
Photo 1 of 2 : SP_2019_NA0010_123_108_20190307_00015.jpg

LM Start	12.81	Rating **	M	Issue No.	108
LM End	12.81	Issue Type +	Ma	Location *	LS
Category	Earthen Levee			GPS Latitude/Longitude	
				Start	End
Item	Encroachments			37.175793 °	37.175793 °
				-120.642227 °	-120.642227 °
DWR ID	DWR_NA0010_05_s_2017_108				
Comment Code					
TR : Tree or limb					
Inspector Comment

Looking upstream at tree branch on landside slope. (Fall 2018)

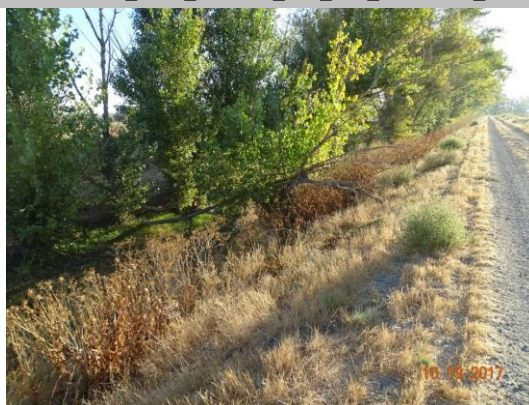
Photo 2 of 2 : SP_2019_NA0010_123_108_20190307_00016.jpg

Looking east at the landside slope. (Fall 2017)

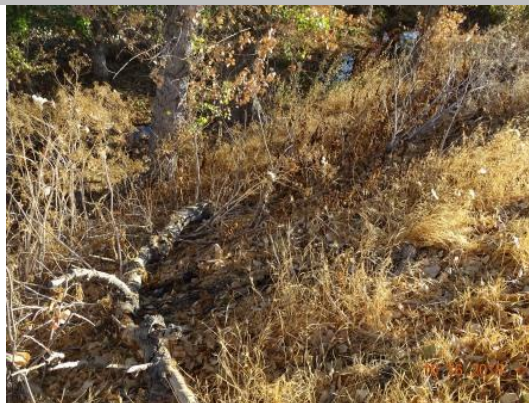
Photo 1 of 1 : SP_2019_NA0010_123_151_20190307_00048.jpg

LM Start	12.85	Rating **	M	Issue No.	151	
LM End	12.85	Issue Type +	Ma	Location *	LS	
Category	Earthen Levee			GPS Latitude/Longitude		
				Start		End
Item	Encroachments			37.175799 °	°	
				-120.641595 °	1.000000 °	
DWR ID	DWR_NA0010_05_f_2018_151					
Comment Code						
TR : Tree or limb						
Inspector Comment

Tree limb discarded on landside slope. (Fall 2018)

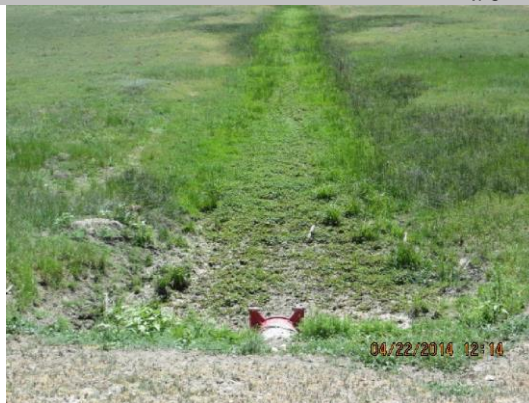
Photo 1 of 3 : UCIP_SP_2019_39593_62240.jpg

Comment Code						
Inspector Comment						
FS_ID:39593						
DS_ID:19707						
EP_NO: N/A						
Repair Type: Non-Urgent						
Crossing Status: Found						
UCIP Comments: 04/22/2014 Sediment buildup in pipe visible from landward side--recommend contacting owner to clear pipe. (DWR UCIP - W. Wylie)						
FIELD_STRUCT_DESC: 24-inch corrugated metal gravity drainage pipe through the levee, 10.2 feet below the crown. Concrete headwall on the landside (LS) end with flashboards. Concrete saddle and apron on the waterside (WS) end with a flap gate. Metal screen at LS toe inlet.						
[Additional Reference(s): DWR Levee Log, 2002. USACE San Joaquin O&M Manual 601.1, 1967, (HLM 12.87)].						
FS Date: 4/22/2014

Headwall, flapgate, and pipe on WS toe.

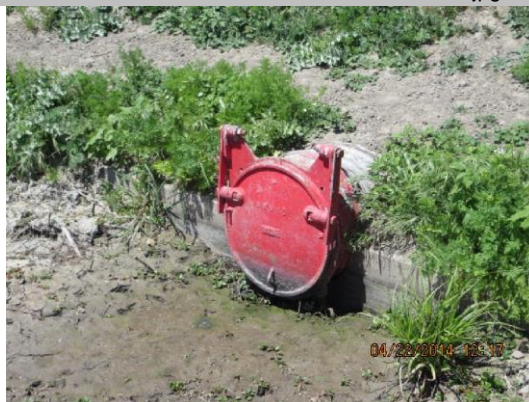
Photo 2 of 3 : UCIP_SP_2019_39593_62241.jpg

Headwall, flapgate, and pipe on WS toe.

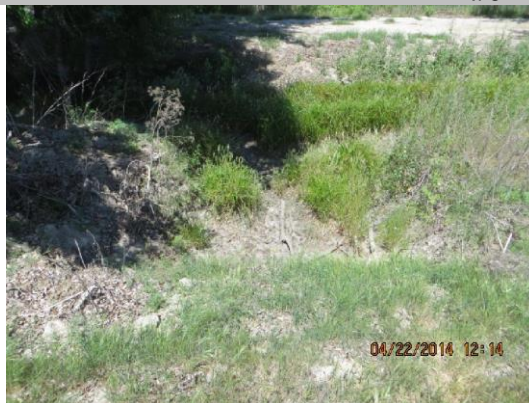
Photo 3 of 3 : UCIP_SP_2019_39593_62239.jpg

Item	DWR UCIP LMA Responsibility			37.175816 °		37.175816 °
				-120.640865 °		-120.640865 °
DWR ID	19707					
Comment Code						
Inspector Comment						
FS_ID:39593 DS_ID:19707 EP_NO: N/A Repair Type: Non-Urgent Crossing Status: Found UCIP Comments: 04/22/2014 Sediment buildup in pipe visible from landward side--recommend contacting owner to clear pipe. (DWR UCIP - W. Wylie) FIELD_STRUCT_DESC: 24-inch corrugated metal gravity drainage pipe through the levee, 10.2 feet below the crown. Concrete headwall on the landside (LS) end with flashboards. Concrete saddle and apron on the waterside (WS) end with a flap gate. Metal screen at LS toe inlet. [Additional Reference(s): DWR Levee Log, 2002. USACE San Joaquin O&M Manual 601.1, 1967, (HLM 12.87)]. FS Date: 4/22/2014

Headwall and pipe on LS toe.

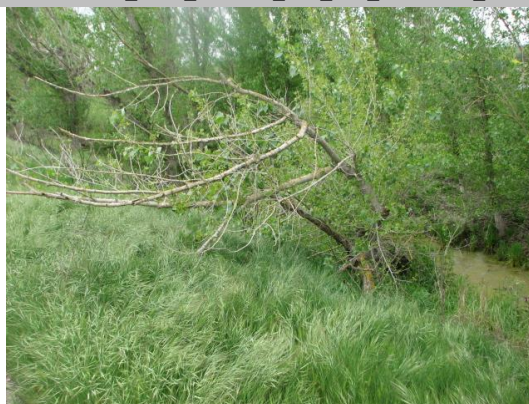
Photo 1 of 1 : SP_2019_NA0010_123_109_20190307_00017.jpg

LM Start	12.93	Rating **	M	Issue No.	109
LM End	12.93	Issue Type +	Ma	Location *	LS
Category	Earthen Levee			GPS Latitude/Longitude	
				Start	End
Item	Encroachments			37.175780 °	37.175780 °
				-120.640195 °	-120.640195 °
DWR ID	DWR_NA0010_05_s_2017_109				
Comment Code					
TR : Tree or limb					
Inspector Comment					
A fallen tree is located on the landside toe.

Looking at broken tree on landward toe. (Spring 2018)

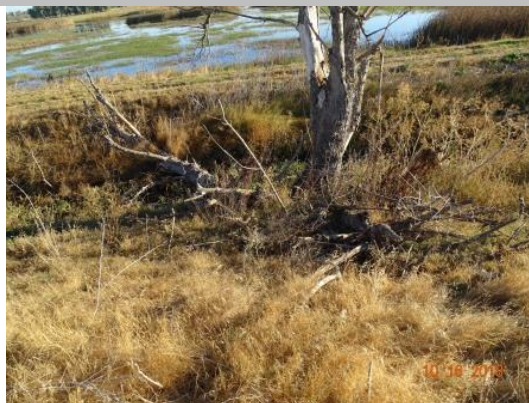
Photo 1 of 1 : SP_2019_NA0010_123_150_20190307_00047.jpg

LM Start	13.05	Rating **	M	Issue No.	150
LM End	13.05	Issue Type +	Ma	Location *	LS
Category	Earthen Levee			GPS Latitude/Longitude	
				Start	End
Item	Encroachments			37.175314 °	37.175314 °
				-120.638034 °	-120.638034 °
DWR ID	DWR_NA0010_05_f_2018_150				
Comment Code					
TR : Tree or limb					
Inspector Comment					
There are tree trimmings on the levee slope and toe.

Tree trimmings on landside slope and toe. (Fall 2018)

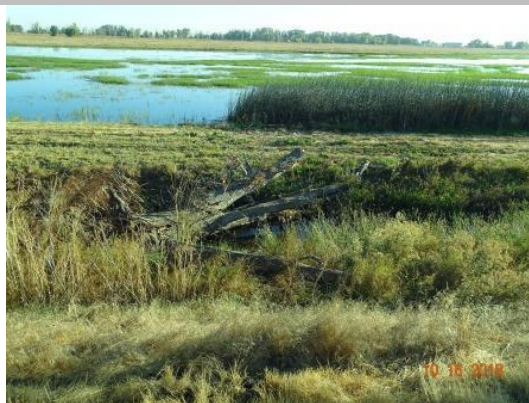
Photo 1 of 1 : SP_2019_NA0010_123_152_20190307_00049.jpg

LM Start	13.15	Rating **	M	Issue No.	152
LM End	13.15	Issue Type +	Ma	Location *	LS
Category	Earthen Levee			GPS Latitude/Longitude	
				Start	End
Item	Encroachments			37.174444 °	37.174444 °
				-120.636589 °	-120.636589 °
DWR ID	DWR_NA0010_05_f_2018_152				
Comment Code					
TR : Tree or limb					
Inspector Comment					
There is a tree trunk on landside toe.

Tree trunk on landside toe. (Fall 2018)

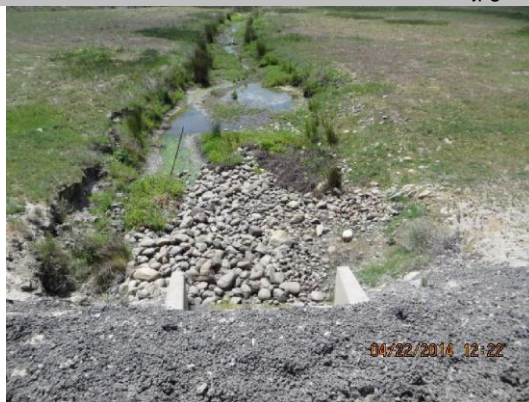
Photo 2 of 3 : UCIP_SP_2019_34288_62243.jpg

Headwall, flapgate, and pipe on WS toe.

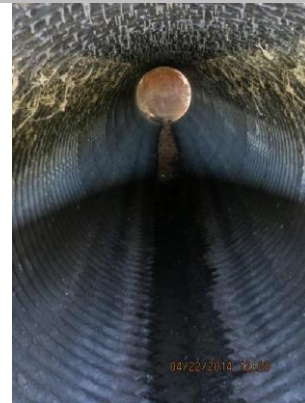
Photo 3 of 3 : UCIP_SP_2019_34288_62242.jpg

Item	DWR UCIP LMA Responsibility			37.171523 °	37.171523 °	
				-120.633442 °	-120.633442 °	
DWR ID	19708					
Comment Code						
Inspector Comment						
FS_ID:34288						
DS_ID:19708						
EP_NO: N/A						
Repair Type: Non-Urgent						
Crossing Status: Found						
UCIP Comments: 04/22/2014 Some erosion around headwall on the WS toe and there are animal burrows on both slopes. (DWR UCIP - W. Wylie)						
FIELD_STRUCT_DESC: 48-inch corrugated metal gravity drainage pipe through the levee, 10 feet below the crown. Flap gate on the waterside (WS) end. Flashboard attachment in concrete U-shaped headwall on the landside (LS) end. Concrete U-shaped headwall on the WS end. [Additional Reference(s): DWR Levee Log, 2002. USACE San Joaquin O&M Manual 601.1, 1967, (HLM 13.40)].						
FS Date: 4/22/2014

Headwall, flapgate, and pipe on WS toe.

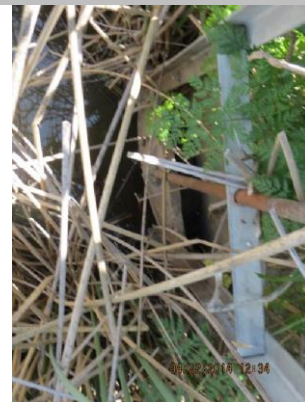
Photo 1 of 2 : UCIP_SP_2019_34824_62624.jpg

Comment Code						
Inspector Comment						
FS_ID:34824 DS_ID:19709 EP_NO: N/A Repair Type: Non-Urgent Crossing Status: Found UCIP Comments: 04/22/2014 Pipe not visible and may need to have silt removed from outlet on WS toe. (DWR UCIP - W. Wylie) FIELD_STRUCT_DESC: 24-inch corrugated metal gravity drainage pipe through the levee, 16 feet below the crown. Flap gate on the waterside (WS) end. Slide gate on concrete headwall at the landside (LS) toe. Concrete saddle and apron on the WS end. [Additional Reference(s): DWR Levee Log, 2002. USACE San Joaquin O&M Manual 601.1, 1967, (recorded as HLM 14.72 should be 13.72)]. FS Date: 4/22/2014

Slide gate at concrete headwall on LS toe.

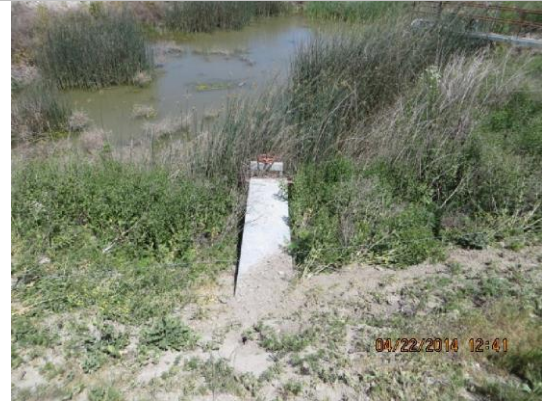
Photo 2 of 2 : UCIP_SP_2019_34824_62623.jpg

Comment Code					
Inspector Comment					
FS_ID:34824 DS_ID:19709 EP_NO: N/A Repair Type: Non-Urgent Crossing Status: Found UCIP Comments: 04/22/2014 Pipe not visible and may need to have silt removed from outlet on WS toe. (DWR UCIP - W. Wylie) FIELD_STRUCT_DESC: 24-inch corrugated metal gravity drainage pipe through the levee, 16 feet below the crown. Flap gate on the waterside (WS) end. Slide gate on concrete headwall at the landside (LS) toe. Concrete saddle and apron on the WS end. [Additional Reference(s): DWR Levee Log, 2002. USACE San Joaquin O&M Manual 601.1, 1967, (recorded as HLM 14.72 should be 13.72)]. FS Date: 4/22/2014

Walkway to gatevalve on LS shoulder.

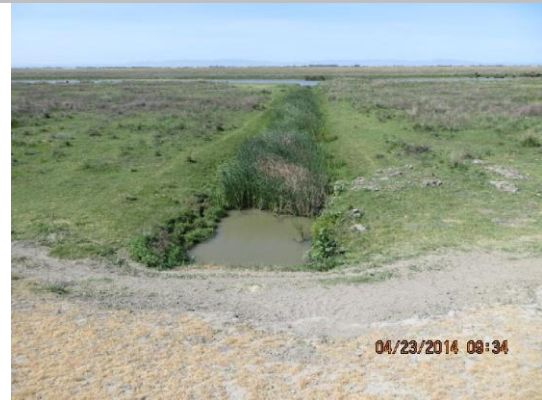
Photo 1 of 3 : UCIP_SP_2019_34657_62450.jpg

LM Start	13.85	Rating **	A/W	Issue No.	1341
LM End	13.85	Issue Type +	Ma	Location *	
Category	Supplemental			GPS Latitude/Longitude	
				Start	End
Item	DWR UCIP LMA Responsibility			37.166760 °	37.166760 °
				-120.628304 °	-120.628304 °
DWR ID	19710				
Comment Code					
Inspector Comment					
FS_ID:34657					
DS_ID:19710					
EP_NO: N/A					
Repair Type: No Action Needed					
Crossing Status: Found					
UCIP Comments:					
FIELD_STRUCT_DESC: 24-inch corrugated metal gravity drainage pipe					
through the levee, 12.4 feet below the crown. Flap gate on the					
waterside (WS) end. Concrete headwall on each end. [Additional					
Reference(s): DWR Levee Log, 2002. USACE San Joaquin O&M					
Manual 601.1, 1967, (HLM 13.83)].					
FS Date: 4/23/2014 4:17:00 PM

Headwall, flapgate, and pipe on WS toe.

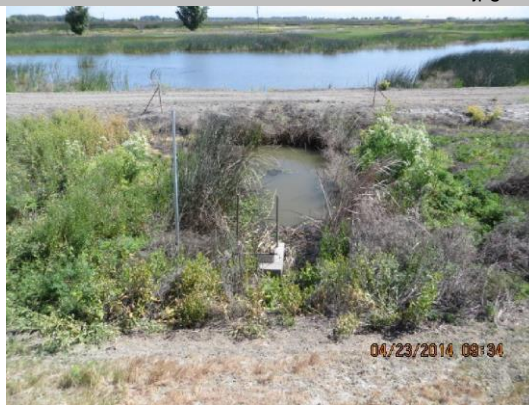
Photo 3 of 3 : UCIP_SP_2019_34657_62449.jpg

Concrete wier intake structure and pipe at LS toe.

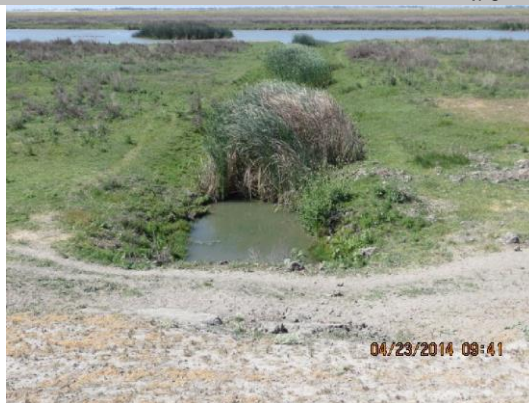
Photo 1 of 3 : UCIP_SP_2019_34656_62446.jpg

LM Start	14.46	Rating **	A/W	Issue No.	1342
LM End	14.46	Issue Type +	Ma	Location *	
Category	Supplemental			GPS Latitude/Longitude	
				Start	End
Item	DWR UCIP LMA Responsibility			37.162722 °	37.162722 °
				-120.618571 °	-120.618571 °
DWR ID	19711				
Comment Code					
Inspector Comment					
FS_ID:34656 DS_ID:19711 EP_NO: N/A Repair Type: No Action Needed Crossing Status: Found UCIP Comments: FIELD_STRUCT_DESC: 24-inch corrugated metal gravity drainage pipe through the levee, 12.5 feet below the crown. Flap gate on the waterside (WS) end. Concrete headwall on each end. Concrete weir inlet structure on the landside (LS) toe. [Additional Reference(s): DWR Levee Log, 2002. USACE San Joaquin O&M Manual 601.1, 1967, (HLM 14.44)]. FS Date: 4/23/2014

Headwall, pipe, and flapgate on WS toe.

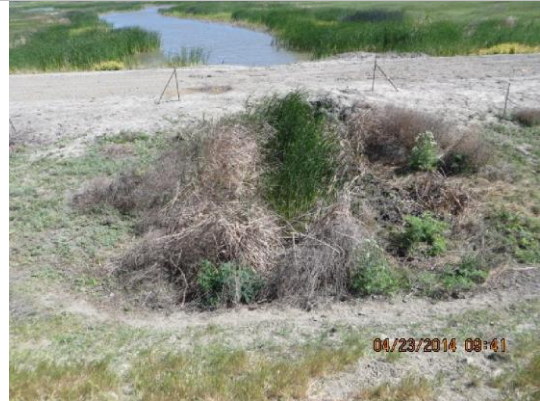
Photo 3 of 3 : UCIP_SP_2019_34656_62445.jpg

LM Start	14.46	Rating **	A/W	Issue No.	1342 (cont)	
LM End	14.46	Issue Type +	Ma	Location *		
Category	Supplemental			GPS Latitude/Longitude		
				Start	End	
Item	DWR UCIP LMA Responsibility			37.162722 °	37.162722 °	
				-120.618571 °	-120.618571 °	
DWR ID	19711					
Comment Code						
Inspector Comment						
FS_ID:34656						
DS_ID:19711						
EP_NO: N/A						
Repair Type: No Action Needed						
Crossing Status: Found						
UCIP Comments:						
FIELD_STRUCT_DESC: 24-inch corrugated metal gravity drainage pipe through the levee, 12.5 feet below the crown. Flap gate on the waterside (WS) end. Concrete headwall on each end. Concrete weir inlet structure on the landside (LS) toe. [Additional Reference(s): DWR Levee Log, 2002. USACE San Joaquin O&M Manual 601.1, 1967, (HLM 14.44)].						
FS Date: 4/23/2014

Concrete weir inlet at LS toe.

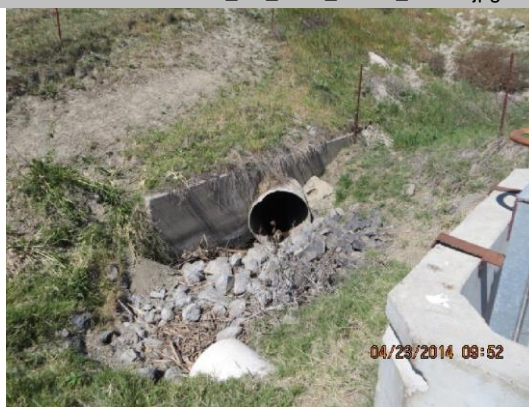
Photo 2 of 3 : UCIP_SP_2019_34664_62453.jpg

Headwall and inlet on LS toe.

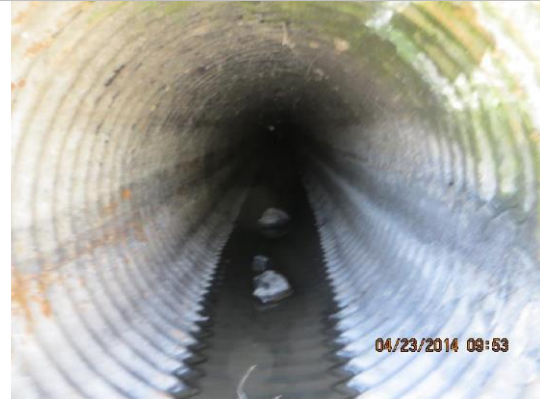
Photo 3 of 3 : UCIP_SP_2019_34664_62452.jpg

LM Start	15.11	Rating **	M	Issue No.	1343 (cont)
LM End	15.11	Issue Type +	Ma	Location *	
Category	Supplemental			GPS Latitude/Longitude	
				Start	End
Item	DWR UCIP LMA Responsibility			37.156805 °	37.156805 °
				-120.609513 °	-120.609513 °
DWR ID	19712				
Comment Code					
Inspector Comment					
FS_ID:34664 DS_ID:19712 EP_NO: N/A Repair Type: Non-Urgent Crossing Status: Found UCIP Comments: 04/23/2014 Minor erosion at headwall on WS toe. (DWR UCIP - W. Wylie) FIELD_STRUCT_DESC: 36-inch corrugated metal gravity drainage pipe through the levee, 11.9 feet below the crown. Flap gate on the waterside (WS) end. Concrete headwall on each end. [Additional Reference(s): DWR Levee Log, 2002. USACE San Joaquin O&M Manual 601.1, 1967, (HLM 15.09)]. FS Date: 4/23/2014

Inside pipe at LS toe.

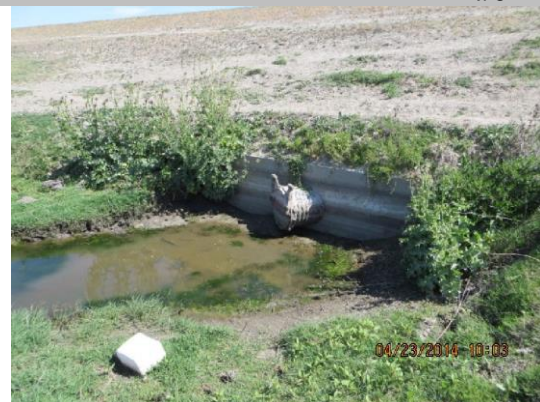
Photo 1 of 3 : UCIP_SP_2019_39595_62459.jpg

LM Start	15.76	Rating **	M	Issue No.	1344	
LM End	15.76	Issue Type +	Ma	Location *		
Category	Supplemental			GPS Latitude/Longitude		
				Start		End
Item	DWR UCIP LMA Responsibility			37.150012 °	37.150012 °	
				-120.601330 °	-120.601330 °	
DWR ID	19713					
Comment Code						
Inspector Comment						
FS_ID:39595 DS_ID:19713 EP_NO: N/A Repair Type: Non-Urgent Crossing Status: Found UCIP Comments: 04/23/2014 Sediment buildup in pipe visible from landward side--recommend contacting owner to clear pipe. (DWR UCIP - W. Wylie) FIELD_STRUCT_DESC: 24-inch corrugated metal gravity drainage pipe through the levee, 11 feet below the crown. Flap gate on the waterside (WS) end. Concrete headwall on each end. [Additional Reference(s): DWR Levee Log, 2002. USACE San Joaquin O&M Manual 601.1, 1967, (HLM 15.74)]. FS Date: 4/23/2014

Headwall, pipe, and flapgate on WS toe.

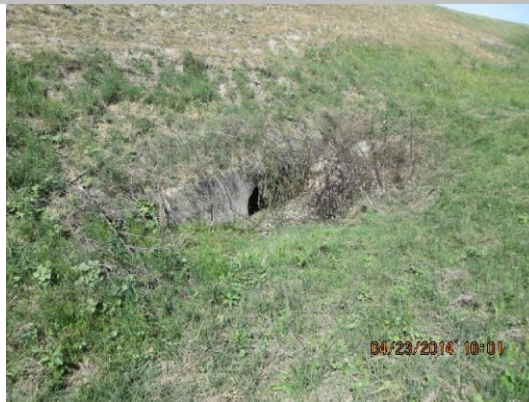
Photo 3 of 3 : UCIP_SP_2019_39595_62458.jpg

Headwall and pipe at LS toe.

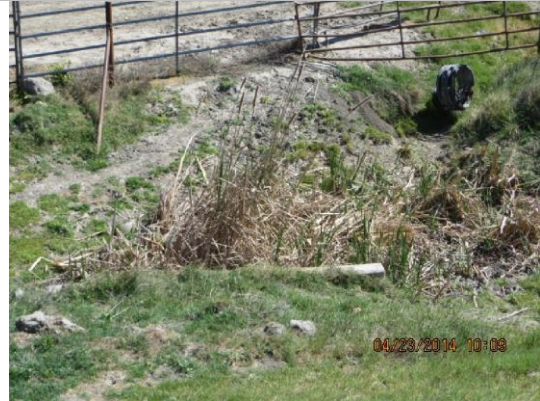
Photo 3 of 3 : UCIP_SP_2019_39596_62466.jpg

LM Start	15.81	Rating **	M	Issue No.	1345 (cont)
LM End	15.81	Issue Type +	Ma	Location *	
Category	Supplemental			GPS Latitude/Longitude	
				Start	End
Item	DWR UCIP LMA Responsibility			37.149381 °	37.149381 °
				-120.600761 °	-120.600761 °
DWR ID	19715				
Comment Code					
Inspector Comment					
FS_ID:39596 DS_ID:19715 EP_NO: N/A Repair Type: Non-Urgent Crossing Status: Found UCIP Comments: 04/23/2014 Excess vegetation at inlet on LS toe through the levee, 12 feet below the crown. Flap gate on the waterside (WS) end. Concrete headwall on the landside (LS) end. Concrete saddle and apron on the WS end. [Additional Reference(s): DWR Levee Log, 2002. USACE San Joaquin O&M Manual 601.1, 1967, (HLM 15.80)]. FS Date: 4/23/2014

Headwall and pipe visible at LS toe.

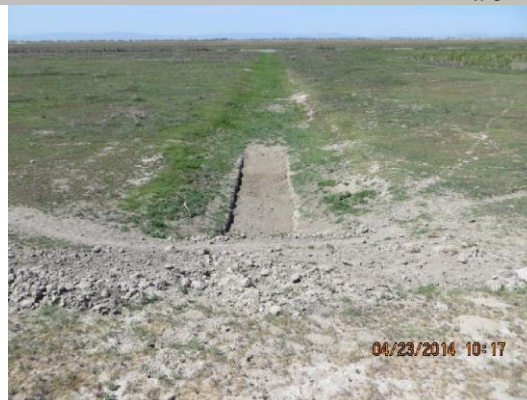
Photo 1 of 3 : UCIP_SP_2019_34725_62469.jpg

LM Start	16.68	Rating **	M	Issue No.	1346	
LM End	16.68	Issue Type +	Ma	Location *		
Category	Supplemental			GPS Latitude/Longitude		
				Start		End
Item	DWR UCIP LMA Responsibility			37.138760 °		37.138760 °
				-120.592393 °		-120.592393 °
DWR ID	19716					
Comment Code						
Inspector Comment						
FS_ID:34725 DS_ID:19716 EP_NO: N/A Repair Type: Non-Urgent Crossing Status: Found UCIP Comments: 04/23/2014 Pipe heavily silted on LS toe. (DWR UCIP - W. Wylie) FIELD_STRUCT_DESC: 24-inch corrugated metal gravity drainage pipe through the levee, 10.5 feet below the crown. Flap gate on the waterside (WS) end. Concrete headwall on each end. [Additional Reference(s): DWR Levee Log, 2002. USACE San Joaquin O&M Manual 601.1, 1967, (HLM 16.67)]. FS Date: 4/23/2014

Headwall, flapgate, and pipe visible on WS toe.

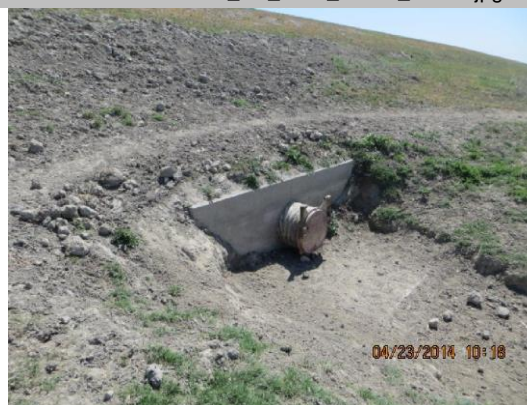
Photo 2 of 3 : UCIP_SP_2019_34725_62471.jpg

Headwall, flapgate, and pipe visible on WS toe.

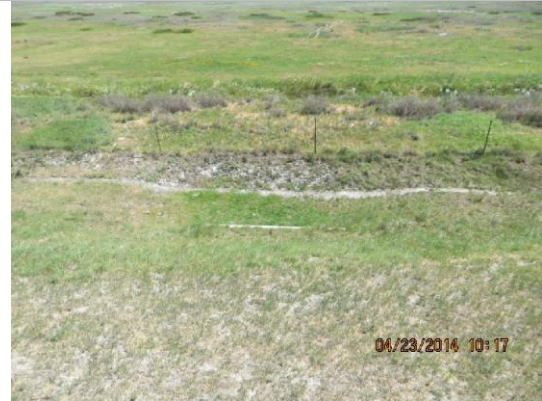
Photo 3 of 3 : UCIP_SP_2019_34725_62470.jpg

LM Start	16.68	Rating **	M	Issue No.	1346 (cont)
LM End	16.68	Issue Type +	Ma	Location *	
Category	Supplemental			GPS Latitude/Longitude	
				Start	End
Item	DWR UCIP LMA Responsibility			37.138760 °	37.138760 °
				-120.592393 °	-120.592393 °
DWR ID	19716				
Comment Code					
Inspector Comment					
FS_ID:34725					
DS_ID:19716					
EP_NO: N/A					
Repair Type: Non-Urgent					
Crossing Status: Found					
UCIP Comments: 04/23/2014 Pipe heavily silted on LS toe. (DWR UCIP - W. Wylie)					
FIELD_STRUCT_DESC: 24-inch corrugated metal gravity drainage pipe through the levee, 10.5 feet below the crown. Flap gate on the waterside (WS) end. Concrete headwall on each end. [Additional Reference(s): DWR Levee Log, 2002. USACE San Joaquin O&M Manual 601.1, 1967, (HLM 16.67)].					
FS Date: 4/23/2014

Concrete headwall and pipe visible on LS toe.

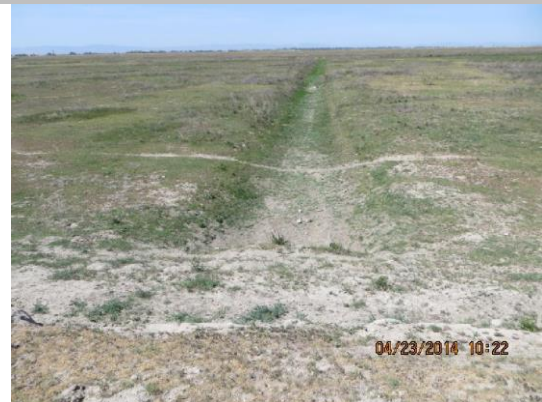
Photo 1 of 3 : UCIP_SP_2019_39597_62481.jpg

LM Start	17.22	Rating **	M	Issue No.	1347
LM End	17.22	Issue Type +	Ma	Location *	
Category	Supplemental			GPS Latitude/Longitude	
				Start	End
Item	DWR UCIP LMA Responsibility			37.132211 °	37.132211 °
				-120.587106 °	-120.587106 °
DWR ID	19717				
Comment Code					
Inspector Comment					
FS_ID:39597					
DS_ID:19717					
EP_NO: N/A					
Repair Type: Non-Urgent					
Crossing Status: Found					
UCIP Comments: 04/23/2014 Sediment buildup in pipe visible from landward side--recommend contacting owner to clear pipe. (DWR UCIP - W. Wylie)					
FIELD_STRUCT_DESC: 24-inch corrugated metal gravity drainage pipe through the levee, 12 feet below the crown. Flap gate on the waterside (WS) end. Concrete headwall on each end. [Additional Reference(s): DWR Levee Log, 2002. USACE San Joaquin O&M Manual 601.1, 1967, (HLM 17.20)].					
FS Date: 4/23/2014

Headwall, flapgate, and pipe visible on WS toe.

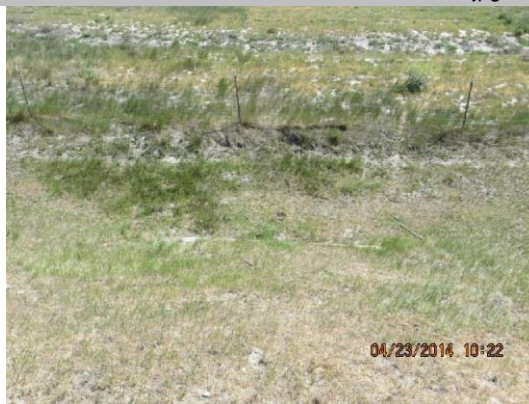
Photo 3 of 3 : UCIP_SP_2019_39597_62482.jpg

Headwall and pipe visible on LS toe.

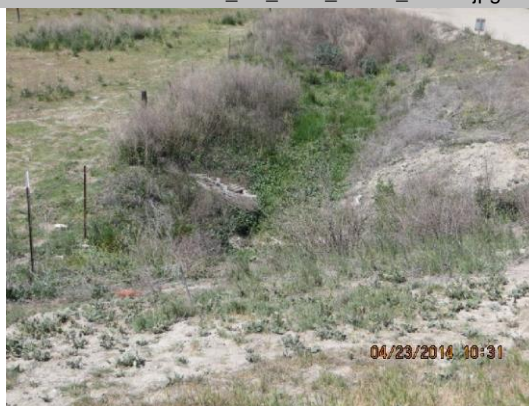
Photo 1 of 3 : UCIP_SP_2019_39599_62485.jpg

LM Start	17.54	Rating **	M	Issue No.	1348	
LM End	17.54	Issue Type +	Ma	Location *		
Category	Supplemental			GPS Latitude/Longitude		
				Start		End
Item	DWR UCIP LMA Responsibility			37.127843 °		37.127843 °
				-120.585245 °		-120.585245 °
DWR ID	19743					
Comment Code						
Inspector Comment						
FS_ID:39599 DS_ID:19743 EP_NO: N/A Repair Type: Non-Urgent Crossing Status: Found UCIP Comments: 04/23/2014 Sediment buildup in pipe visible from landward side--recommend contacting owner to clear pipe. (DWR UCIP - W. Wylie) FIELD_STRUCT_DESC: 24-inch corrugated metal gravity drainage pipe through the levee, 9.8 feet below the crown. Flap gate on the waterside (WS) end. Concrete headwall on each end. [Additional Reference(s): DWR Levee Log, 2002. USACE San Joaquin O&M Manual 601.1, 1967, (HLM 17.52)]. FS Date: 4/23/2014

Headwall, pipe, and flapgate visible on WS toe.

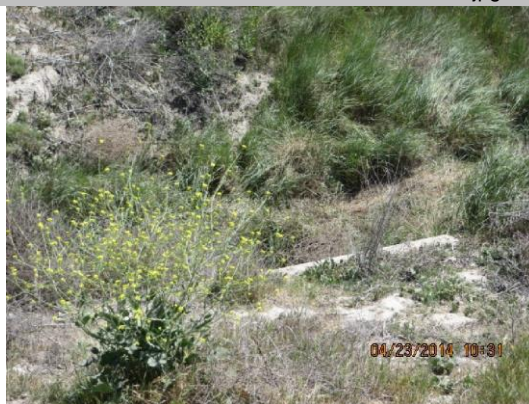
Photo 2 of 3 : UCIP_SP_2019_39599_62486.jpg

Pipe and headwall visible on LS toe.
