**Flood Control Project Maintenance
Levee Inspections**
LMA District Cover Sheet
Spring 2019 Levee Inspection Results

Lower San Joaquin Levee District

Spring 2019 Levee Inspection Results

Waterway			Bank	Unit Miles
Unit No. 01 San Joaquin River			Right	22.52
	Spring (March - May)	Summer (June - August)	(September - November) Fall	Winter (December - February)
Unit Maintenance Rating (Fall Only)				
Date of Inspection	3/26/2019 - 3/26/2019			
DWR Inspector	Corey Fujitani			
Accompanied By

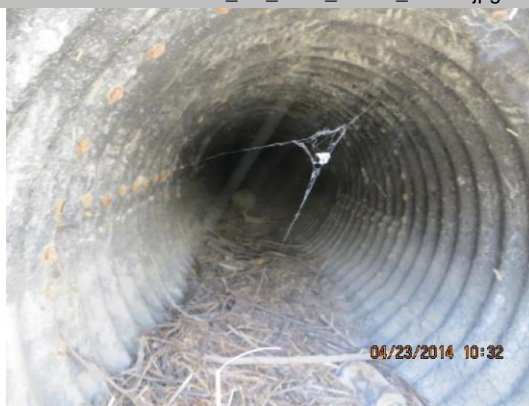
Photo 3 of 3 : UCIP_SP_2019_39599_62488.jpg

LM Start	17.54	Rating **	M	Issue No.	1348 (cont)	
LM End	17.54	Issue Type +	Ma	Location *		
Category	Supplemental			GPS Latitude/Longitude		
				Start		End
Item	DWR UCIP LMA Responsibility			37.127843 °		37.127843 °
				-120.585245 °		-120.585245 °
DWR ID	19743					
Comment Code						
Inspector Comment						
FS_ID:39599 DS_ID:19743 EP_NO: N/A Repair Type: Non-Urgent Crossing Status: Found UCIP Comments: 04/23/2014 Sediment buildup in pipe visible from landward side--recommend contacting owner to clear pipe. (DWR UCIP - W. Wylie) FIELD_STRUCT_DESC: 24-inch corrugated metal gravity drainage pipe through the levee, 9.8 feet below the crown. Flap gate on the waterside (WS) end. Concrete headwall on each end. [Additional Reference(s): DWR Levee Log, 2002. USACE San Joaquin O&M Manual 601.1, 1967, (HLM 17.52)]. FS Date: 4/23/2014

Inside pipe on LS toe.

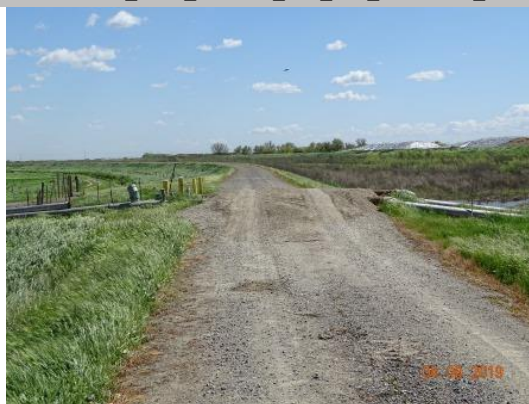
Photo 1 of 3 : SP_2019_NA0010_123_112_20190423_00339.jpg

LM Start	18.06	Rating **	U	Issue No.	112
LM End	18.06	Issue Type +	En	Location *	CR
Category	Earthen Levee			GPS Latitude/Longitude	
				Start	End
Item	Encroachments			37.120690 °	37.120690 °
				-120.582218 °	-120.582218 °
DWR ID	DWR_NA0010_05_s_2017_112				
Comment Code					
PI : Pipe					
Inspector Comment					
There are 3 temporary eight inch pipes across the levee crown going down both slopes.

View of pipe encroachment looking upstream along the levee crown.
(Spring 2019)

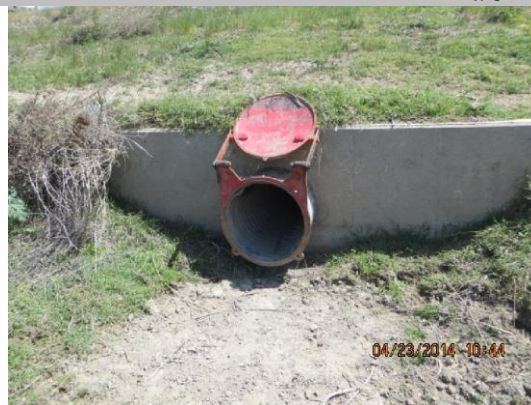
Photo 2 of 3 : UCIP_SP_2019_34747_62495.jpg

LM Start	18.09	Rating **	M	Issue No.	1349
LM End	18.09	Issue Type +	Ma	Location *	
Category	Supplemental			GPS Latitude/Longitude	
				Start	End
Item	DWR UCIP LMA Responsibility			37.120309 °	37.120309 °
				-120.582041 °	-120.582041 °
DWR ID	19745				
Comment Code					
Inspector Comment					
FS_ID:34747 DS_ID:19745 EP_NO: N/A Repair Type: Non-Urgent Crossing Status: Found UCIP Comments: 04/23/2014 Animal burrows in levee on both slopes. (DWR UCIP - W. Wylie) FIELD_STRUCT_DESC: 24-inch corrugated metal gravity drainage pipe through the levee, 12.4 feet below the crown. Flap gate on the waterside (WS) end. Concrete headwall on each end. [Additional Reference(s): DWR Levee Log, 2002. USACE San Joaquin O&M Manual 601.1, 1967, (HLM 18.07)]. FS Date: 4/23/2014

Headwall, pipe, and flapgate on WS toe.

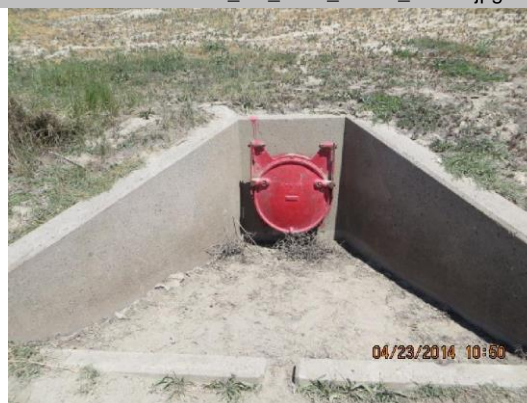
Photo 2 of 3 : UCIP_SP_2019_39600_62498.jpg

Item	DWR UCIP LMA Responsibility			37.115472 °	37.115472 °	
				-120.573628 °	-120.573628 °	
DWR ID	19746					
Comment Code						
Inspector Comment						
FS_ID:39600 DS_ID:19746 EP_NO: N/A Repair Type: Non-Urgent Crossing Status: Found UCIP Comments: 04/23/2014 Dense vegetation limits the inspector's visibility to identify signs of pipe failure (leaks) along the landward slope. Recommend removing vegetation along pipe alignment to conduct proper inspection of structure. (DWR UCIP - W. Wylie) FIELD_STRUCT_DESC: 24-inch corrugated metal gravity drainage pipe through the levee, 10 feet below the crown. Flap gate on the waterside (WS) end. Concrete headwall on the landside (LS) end. Concrete U-shaped headwall on the WS end. [Additional Reference(s): DWR Levee Log, 2002. USACE San Joaquin O&M Manual 601.1, 1967, (HLM 18.68)]. FS Date: 4/23/2014

Headwall, pipe and flapgate visible on WS toe.

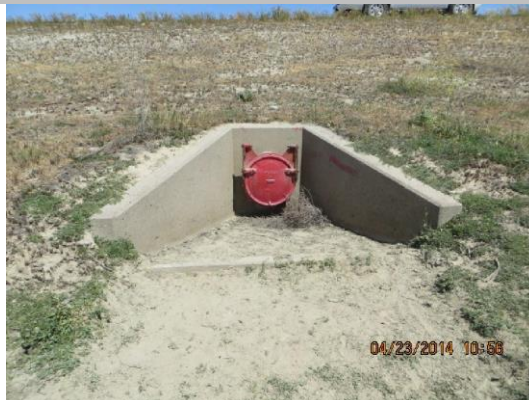
Photo 2 of 3 : UCIP_SP_2019_39601_62506.jpg

LM Start	19.15	Rating **	M	Issue No.	1351	
LM End	19.15	Issue Type +	Ma	Location *		
Category	Supplemental			GPS Latitude/Longitude		
				Start		End
Item	DWR UCIP LMA Responsibility			37.115466 °		37.115466 °
				-120.565467 °		-120.565467 °
DWR ID	19747					
Comment Code						
Inspector Comment						
FS_ID:39601 DS_ID:19747 EP_NO: N/A Repair Type: Non-Urgent Crossing Status: Found UCIP Comments: 04/23/2014 Sediment buildup in pipe visible from landward side--recommend contacting owner to clear pipe. (DWR UCIP - W. Wylie) FIELD_STRUCT_DESC: 24-inch corrugated metal gravity drainage pipe through the levee, 10 feet below the crown. Flap gate on the waterside (WS) end. Concrete headwall on the landside (LS) end. Concrete U-shaped headwall on the WS end. [Additional Reference(s): DWR Levee Log, 2002. USACE San Joaquin O&M Manual 601.1, 1967, (HLM 19.11)]. FS Date: 4/23/2014

Headwall, pipe, and flapgate visible on WS toe.

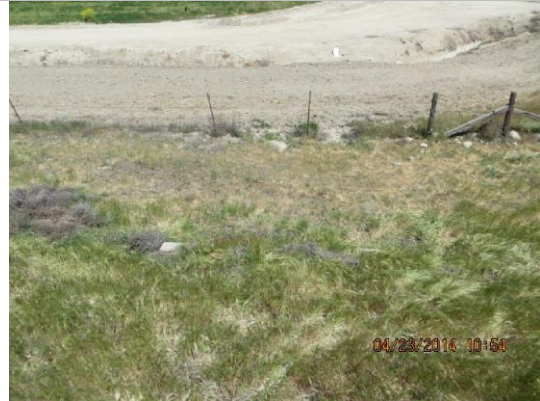
Photo 3 of 3 : UCIP_SP_2019_39601_62505.jpg

LM Start	19.15	Rating **	M	Issue No.	1351 (cont)	
LM End	19.15	Issue Type +	Ma	Location *		
Category	Supplemental			GPS Latitude/Longitude		
				Start	End	
Item	DWR UCIP LMA Responsibility			37.115466 °	37.115466 °	
				-120.565467 °	-120.565467 °	
DWR ID	19747					
Comment Code						
Inspector Comment						
FS_ID:39601 DS_ID:19747 EP_NO: N/A Repair Type: Non-Urgent Crossing Status: Found UCIP Comments: 04/23/2014 Sediment buildup in pipe visible from landward side--recommend contacting owner to clear pipe. (DWR UCIP - W. Wylie) FIELD_STRUCT_DESC: 24-inch corrugated metal gravity drainage pipe through the levee, 10 feet below the crown. Flap gate on the waterside (WS) end. Concrete headwall on the landside (LS) end. Concrete U-shaped headwall on the WS end. [Additional Reference(s): DWR Levee Log, 2002. USACE San Joaquin O&M Manual 601.1, 1967, (HLM 19.11)]. FS Date: 4/23/2014

Headwall and pipe visible on LS toe.

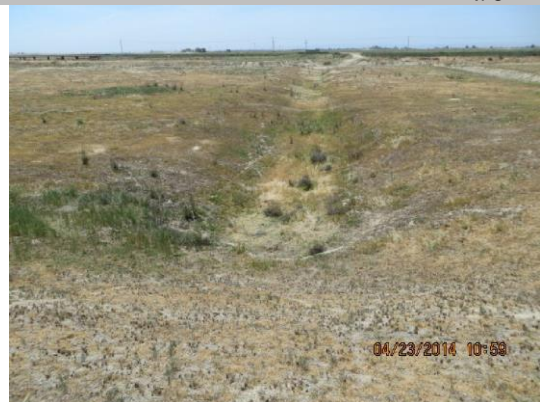
Photo 1 of 3 : UCIP_SP_2019_34751_62509.jpg

LM Start	19.17	Rating **	A/W	Issue No.	1352
LM End	19.17	Issue Type +	Ma	Location *	
Category	Supplemental			GPS Latitude/Longitude	
				Start	End
Item	DWR UCIP LMA Responsibility			37.115463 °	37.115463 °
				-120.565086 °	-120.565086 °
DWR ID	19776				
Comment Code					
Inspector Comment					
FS_ID:34751					
DS_ID:19776					
EP_NO: N/A					
Repair Type: No Action Needed					
Crossing Status: Found					
UCIP Comments:					
FIELD_STRUCT_DESC: 24-inch corrugated metal gravity drainage pipe through the levee, 10.3 feet below the crown. Flap gate on the waterside (WS) end. Concrete headwall on the landside (LS) end. Concrete U-shaped headwall on the WS end. [Additional Reference(s): DWR Levee Log, 2002. USACE San Joaquin O&M Manual 601.1, 1967, (HLM 19.15)].					
FS Date: 4/23/2014

Headwall, pipe, and flapgate visible on WS toe.

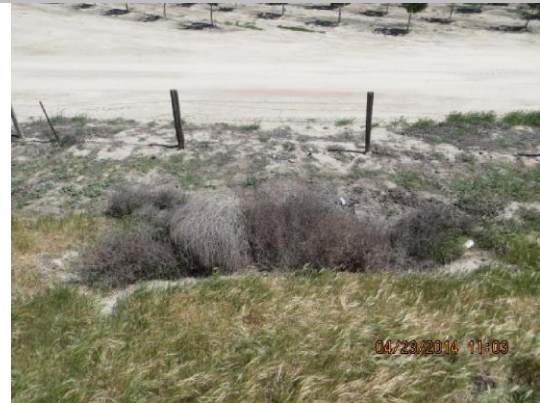
Photo 3 of 3 : UCIP_SP_2019_39602_62515.jpg

LM Start	19.48	Rating **	M	Issue No.	1353 (cont)	
LM End	19.48	Issue Type +	Ma	Location *		
Category	Supplemental			GPS Latitude/Longitude		
				Start		End
Item	DWR UCIP LMA Responsibility			37.113542 °		37.113542 °
				-120.560389 °		-120.560389 °
DWR ID	19777					
Comment Code						
Inspector Comment						
FS_ID:39602 DS_ID:19777 EP_NO: N/A Repair Type: Non-Urgent Crossing Status: Found UCIP Comments: 04/23/2014 Sediment buildup in pipe visible from landward side--recommend contacting owner to clear pipe. (DWR UCIP - W. Wylie) FIELD_STRUCT_DESC: 24-inch corrugated metal gravity drainage pipe through the levee, 9 feet below the crown. Flap gate on the waterside (WS) end. Concrete headwall on the landside (LS) end. Concrete U-shaped headwall on the WS end. [Additional Reference(s): DWR Levee Log, 2002. USACE San Joaquin O&M Manual 601.1, 1967, (HLM 19.46)]. FS Date: 4/23/2014

Headwall and pipe visible on LS toe.

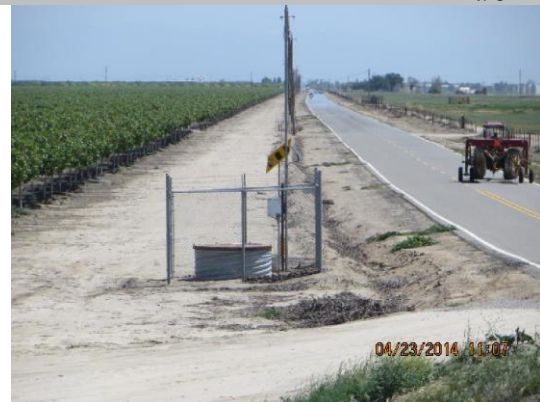
Photo 1 of 2 : UCIP_SP_2019_39345_71477.jpg

LM Start	19.51	Rating **	M	Issue No.	1354	
LM End	19.51	Issue Type +	En	Location *		
Category	Supplemental			GPS Latitude/Longitude		
				Start	End	
Item	DWR UCIP Field Study			37.113172 °	37.113172 °	
				-120.560014 °	-120.560014 °	
DWR ID	24868					
Comment Code						
Inspector Comment						
FS_ID:39345						
DS_ID:24868						
EP_NO: N/A						
Repair Type: Non-Urgent						
Crossing Status: Indicator Found						
UCIP Comments: 04/23/2014 Markers closer to the levee may be necessary to properly mark pipe crossing location. (DWR UCIP - W. Wylie)						
FIELD_STRUCT_DESC: Steel natural gas pipeline of an unknown size through the levee, at an unknown depth. Corrugated metal pipe (CMP) riser and gas line marker off the landside (LS) toe.						
FS Date: 4/22/2014

Gasline marker off LS toe.

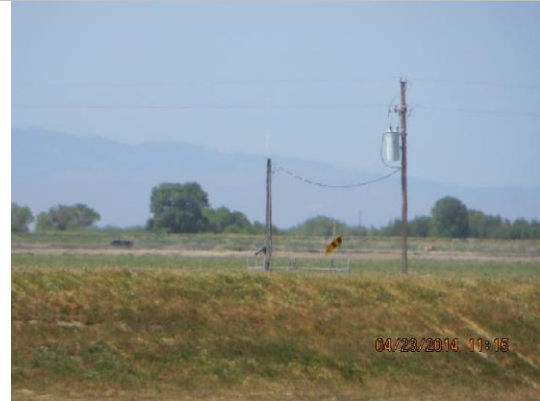
Photo 2 of 2 : UCIP_SP_2019_39345_71476.jpg

LM Start	19.51	Rating **	M	Issue No.	1354 (cont)	
LM End	19.51	Issue Type +	En	Location *		
Category	Supplemental			GPS Latitude/Longitude		
				Start		End
Item	DWR UCIP Field Study			37.113172 °		37.113172 °
				-120.560014 °		-120.560014 °
DWR ID	24868					
Comment Code						
Inspector Comment						
FS_ID:39345						
DS_ID:24868						
EP_NO: N/A						
Repair Type: Non-Urgent						
Crossing Status: Indicator Found						
UCIP Comments: 04/23/2014 Markers closer to the levee may be necessary to properly mark pipe crossing location. (DWR UCIP - W. Wylie)						
FIELD_STRUCT_DESC: Steel natural gas pipeline of an unknown size through the levee, at an unknown depth. Corrugated metal pipe (CMP) riser and gas line marker off the landside (LS) toe.						
FS Date: 4/22/2014

Gasline marker off LS of opposite bank.

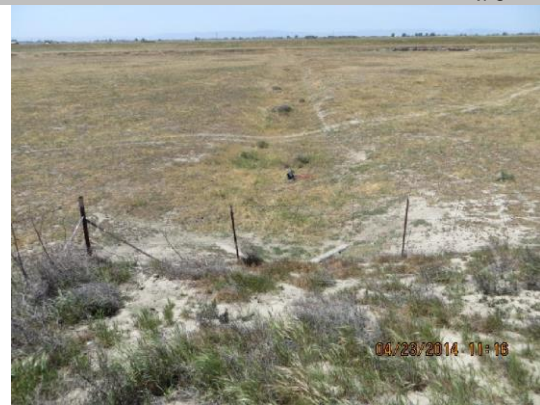
Photo 1 of 3 : UCIP_SP_2019_39603_62519.jpg

Comment Code					
Inspector Comment					
FS_ID:39603 DS_ID:19778 EP_NO: N/A Repair Type: Non-Urgent Crossing Status: Found UCIP Comments: 04/23/2014 Dense vegetation limits the inspector's visibility to identify signs of pipe failure (leaks) along the landward slope. Recommend removing vegetation along pipe alignment to conduct proper inspection of structure. Sediment buildup in pipe visible from landward side--recommend contacting owner to clear pipe. (DWR UCIP - W. Wylie) FIELD_STRUCT_DESC: 24-inch corrugated metal gravity drainage pipe through the levee, 9.7 feet below the crown. Flap gate on the waterside (WS) end. Concrete headwall on the landside (LS) end. Concrete U-shaped headwall on the WS end. [Additional Reference(s): DWR Levee Log, 2002. USACE San Joaquin O&M Manual 601.1, 1967, (HLM 19.50)]. FS Date: 4/23/2014

Headwall, pipe, and flapgate visible on WS toe.

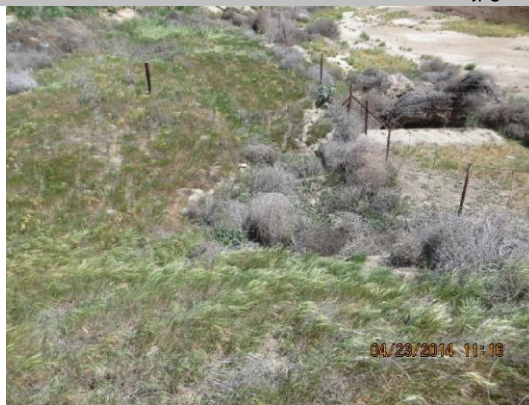
Photo 3 of 3 : UCIP_SP_2019_39603_62520.jpg

Item	DWR UCIP LMA Responsibility			37.112953 °	37.112953 °	
				-120.559943 °	-120.559943 °	
DWR ID	19778					
Comment Code						
Inspector Comment						
FS_ID:39603 DS_ID:19778 EP_NO: N/A Repair Type: Non-Urgent Crossing Status: Found UCIP Comments: 04/23/2014 Dense vegetation limits the inspector's visibility to identify signs of pipe failure (leaks) along the landward slope. Recommend removing vegetation along pipe alignment to conduct proper inspection of structure. Sediment buildup in pipe visible from landward side--recommend contacting owner to clear pipe. (DWR UCIP - W. Wylie) FIELD_STRUCT_DESC: 24-inch corrugated metal gravity drainage pipe through the levee, 9.7 feet below the crown. Flap gate on the waterside (WS) end. Concrete headwall on the landside (LS) end. Concrete U-shaped headwall on the WS end. [Additional Reference(s): DWR Levee Log, 2002. USACE San Joaquin O&M Manual 601.1, 1967, (HLM 19.50)]. FS Date: 4/23/2014

Headwall and pipe visible on LS toe.

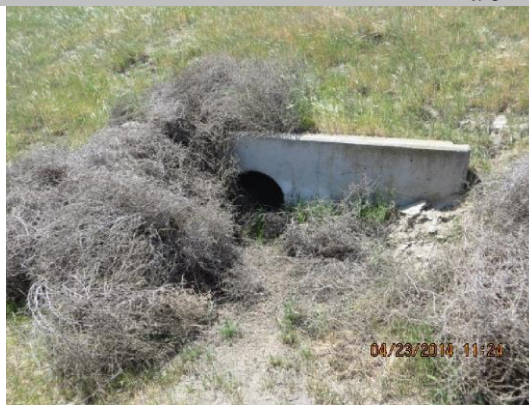
Photo 2 of 3 : UCIP_SP_2019_34754_62524.jpg

LM Start	19.86	Rating **	A/W	Issue No.	1356
LM End	19.86	Issue Type +	Ma	Location *	
Category	Supplemental			GPS Latitude/Longitude	
				Start	End
Item	DWR UCIP LMA Responsibility			37.109284 °	37.109284 °
				-120.555948 °	-120.555948 °
DWR ID	19779				
Comment Code					
Inspector Comment					
FS_ID:34754 DS_ID:19779 EP_NO: N/A Repair Type: No Action Needed Crossing Status: Found UCIP Comments: FIELD_STRUCT_DESC: 24-inch corrugated metal gravity drainage pipe through the levee, 10.3 feet below the crown. Flap gate on the waterside (WS) end. Concrete headwall on the landside (LS) end. Concrete U-shaped headwall on the WS end. [Additional Reference(s): DWR Levee Log, 2002. USACE San Joaquin O&M Manual 601.1, 1967, (HLM 19.84)]. FS Date: 4/23/2014

Headwall and pipe visible on LS toe.

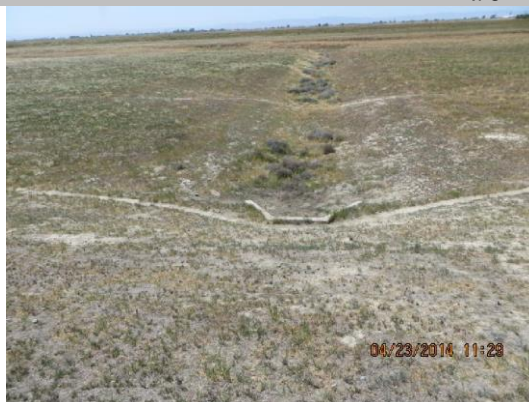
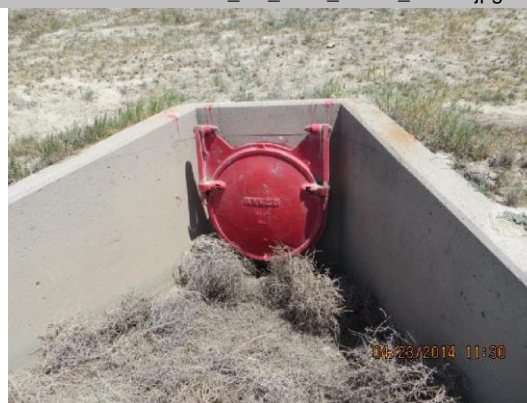
LM Start	19.94	Rating **	A/W	Issue No.	1357
LM End	19.94	Issue Type +	Ma	Location *	
Category	Supplemental			GPS Latitude/Longitude	
				Start	End
Item	DWR UCIP LMA Responsibility			37.108426 °	37.108426 °
				-120.554990 °	-120.554990 °
DWR ID	19780				
Comment Code					
Inspector Comment					
FS_ID:34755 DS_ID:19780 EP_NO: N/A Repair Type: No Action Needed Crossing Status: Found UCIP Comments: FIELD_STRUCT_DESC: 36-inch corrugated metal gravity drainage pipe through the levee, 9.8 feet below the crown. Flap gate on the waterside (WS) end. Concrete headwall on the landside (LS) end. Concrete U-shaped headwall on the WS end. [Additional Reference(s): DWR Levee Log, 2002. USACE San Joaquin O&M Manual 601.1, 1967, (HLM 19.92)]. FS Date: 4/23/2014

Headwall, pipe, and flapgate visible on WS toe.

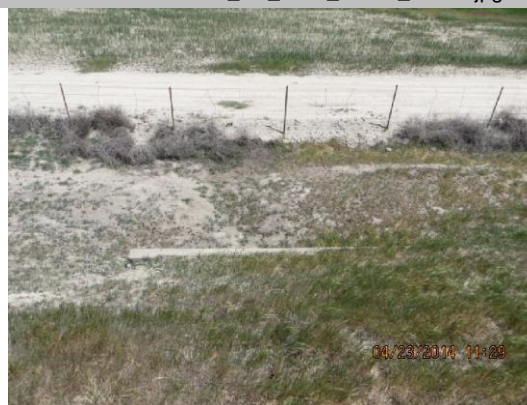
Headwall and pipe visible on LS toe.

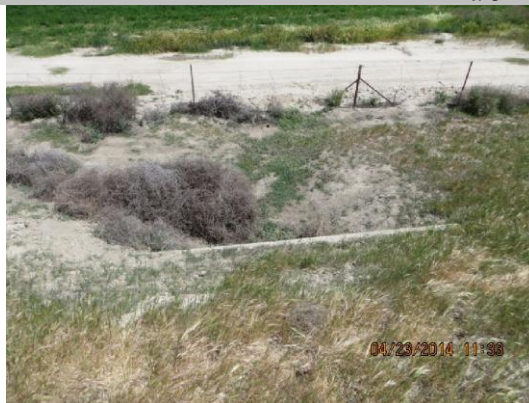
Headwall and pipe visible on LS toe.

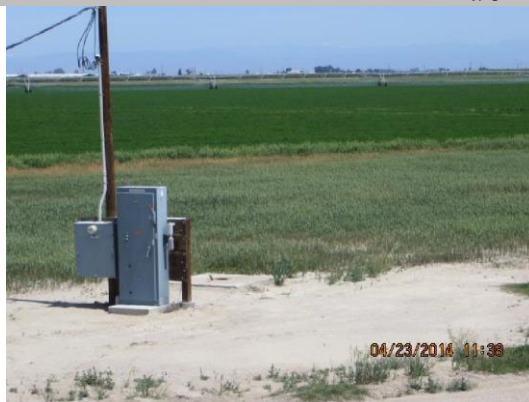
LM Start	20.19	Rating **	M	Issue No.	1359
LM End	20.19	Issue Type +	En	Location *	
Category	Supplemental			GPS Latitude/Longitude	
				Start	End
Item	DWR UCIP Field Study			37.106149 °	37.106149 °
				-120.552538 °	-120.552538 °
DWR ID	19782				
Comment Code					
Inspector Comment					
FS_ID:34759 DS_ID:19782 EP_NO: 13828 Repair Type: Non-Urgent Crossing Status: Not Found UCIP Comments: FIELD_STRUCT_DESC: *DELETE* NOT INSTALLED THROUGH THE LEVEE. 24-inch steel irrigation pipe through the levee, 4.0 feet below the crown. Pump missing from pad on the landward side. Steel cutoff wall around pipe at center of levee. Siphon breaker on apex of pipe on landward shoulder. Pre-existing ditch runs from waterward toe to channel. Pipe extends from pump to the channel. Rock revetment on the cut slopes of the inlet channel. (Permit No. 13828-1988) FS Date: 4/23/2014

Well head visible off LS toe.

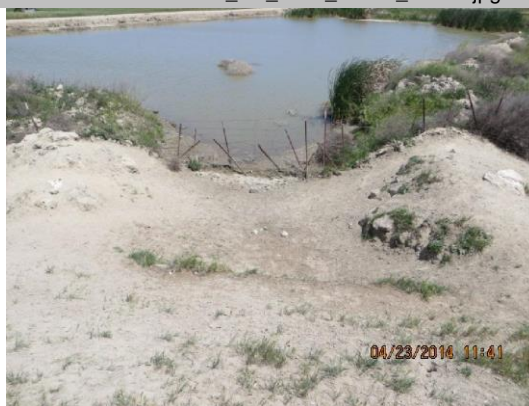
Headwall and pipe visible on LS toe.

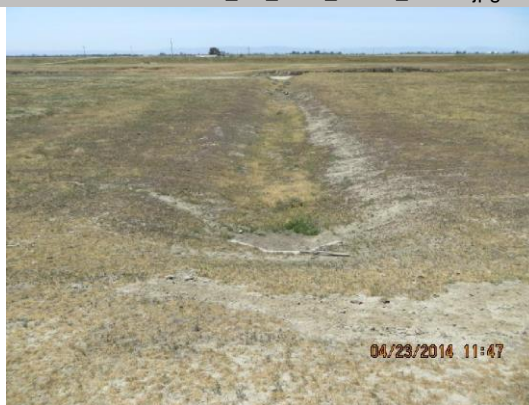
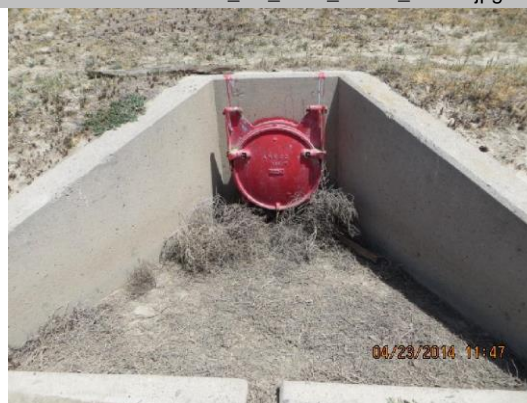
Comment Code					
Inspector Comment					
FS_ID:39605 DS_ID:19784 EP_NO: N/A Repair Type: Non-Urgent Crossing Status: Found UCIP Comments: 04/23/2014 Dense vegetation limits the inspector's visibility to identify signs of pipe failure (leaks) along the landward slope. Recommend removing vegetation along pipe alignment to conduct proper inspection of structure. (DWR UCIP - W. Wylie) FIELD_STRUCT_DESC: 24-inch corrugated metal gravity drainage pipe through the levee, 10.5 feet below the crown. Flap gate on the waterside (WS) end. Concrete headwall on the landside (LS) end. Concrete U-shaped headwall on the WS end. [Additional Reference(s): DWR Levee Log, 2002. USACE San Joaquin O&M Manual 601.1, 1967, (HLM 20.59)]. FS Date: 4/23/2014

Headwall, pipe, and flapgate visible on WS toe.

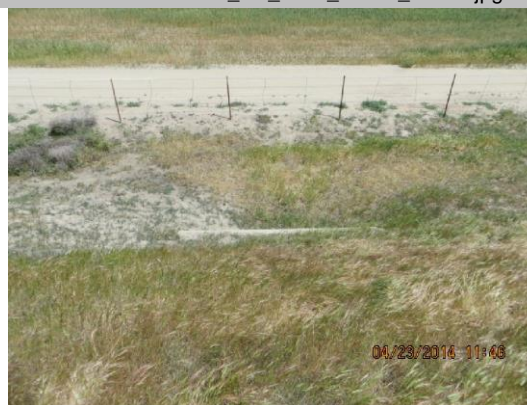
Headwall and pipe visible on LS toe.

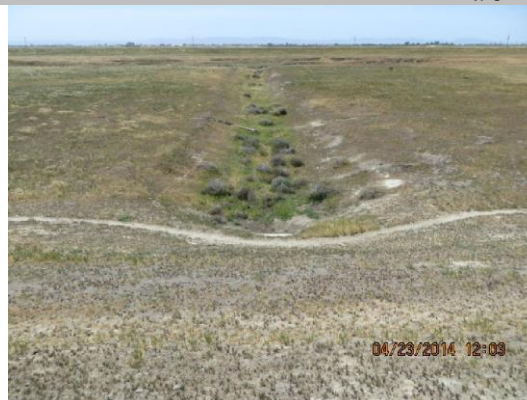
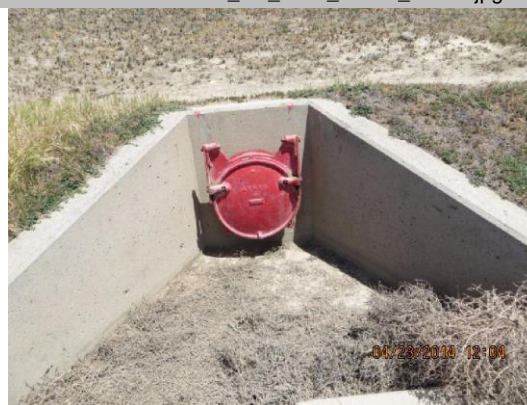
Comment Code					
Inspector Comment					
FS_ID:39606 DS_ID:19785 EP_NO: N/A Repair Type: Non-Urgent Crossing Status: Found UCIP Comments: 04/23/2014 Dense vegetation limits the inspector's visibility to identify signs of pipe failure (leaks) along the landward slope. Recommend removing vegetation along pipe alignment to conduct proper inspection of structure. (DWR UCIP - W. Wylie) FIELD_STRUCT_DESC: 24-inch corrugated metal gravity drainage pipe through the levee, 11.8 feet below the crown. Flap gate on the waterside (WS) end. Concrete headwall on the landside (LS) end. Concrete U-shaped headwall on the WS end. [Additional Reference(s): DWR Levee Log, 2002. USACE San Joaquin O&M Manual 601.1, 1967, (HLM 21.08)]. FS Date: 4/23/2014

Headwall, pipe, and flapgate visible on WS toe.

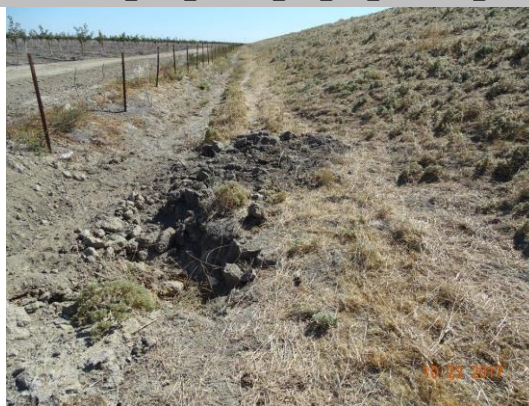
LM Start	21.45	Rating **	M	Issue No.	120
LM End	21.45	Issue Type +	Ma	Location *	LS
Category	Earthen Levee			GPS Latitude/Longitude	
				Start	End
Item	Erosion / Bank Caving			37.092064 °	37.092064 °
				-120.537750 °	-120.537750 °
DWR ID	DWR_NA0010_05_f_2017_120				
Comment Code					
E2 : Schedule repair of erosion site prior to the next inspection.					
Inspector Comment					
Repair holes dug at the landside toe.

Looking southeast at the landside toe.

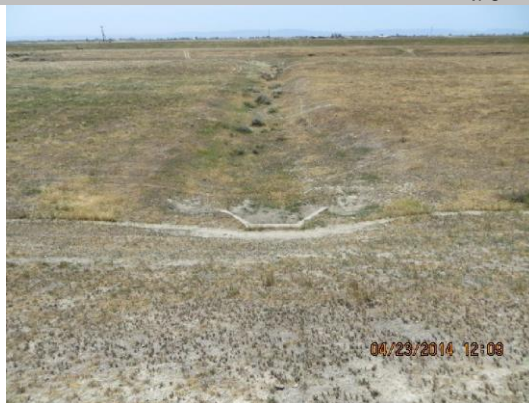
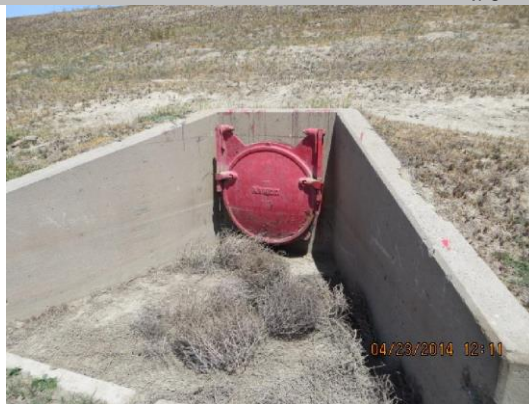
Comment Code					
Inspector Comment					
FS_ID:39614 DS_ID:19786 EP_NO: N/A Repair Type: Non-Urgent Crossing Status: Found UCIP Comments: 04/23/2014 Dense vegetation limits the inspector's visibility to identify signs of pipe failure (leaks) along the landward slope. Recommend removing vegetation along pipe alignment to conduct proper inspection of structure. (DWR UCIP - W. Wylie) FIELD_STRUCT_DESC: 36-inch corrugated metal gravity drainage pipe through the levee, 12.7 feet below the crown. Flap gate on the waterside (WS) end. Concrete headwall on the landside (LS) end. Concrete U-shaped headwall on the WS end. [Additional Reference(s): DWR Levee Log, 2002. USACE San Joaquin O&M Manual 601.1, 1967, (HLM 21.42)]. FS Date: 4/23/2014

Headwall, pipe, and flapgate visible on WS toe.

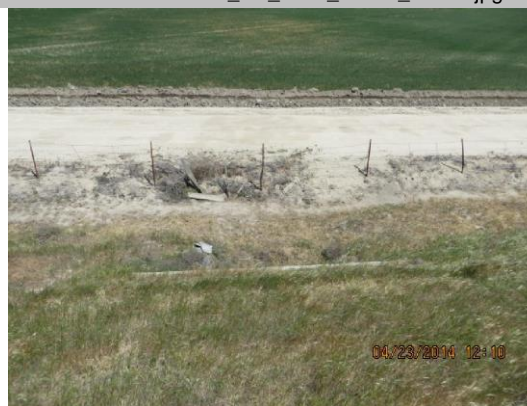
Headwall and pipe visible on LS toe.

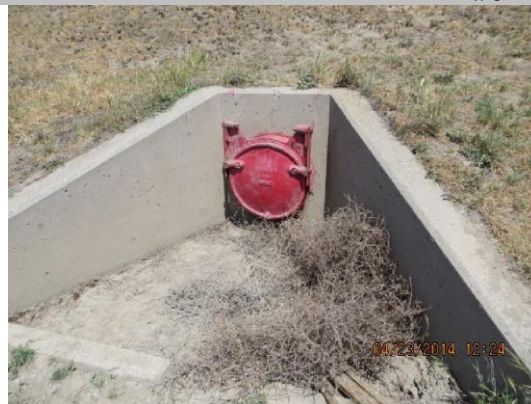
Comment Code					
Inspector Comment					
FS_ID:39883 DS_ID:19787 EP_NO: N/A Repair Type: Non-Urgent Crossing Status: Found UCIP Comments: 04/23/2014 Dense vegetation limits the inspector's visibility to identify signs of pipe failure (leaks) along the landward slope. Recommend removing vegetation along pipe alignment to conduct proper inspection of structure. (DWR UCIP - W. Wylie) FIELD_STRUCT_DESC: 24-inch corrugated metal gravity drainage pipe through the levee, 12.4 feet below the crown. Flap gate on the waterside (WS) end. Concrete headwall on the landside (LS) end. Concrete U-shaped headwall on the WS end. [Additional Reference(s): DWR Levee Log, 2002. USACE San Joaquin O&M Manual 601.1, 1967, (HLM 21.81)]. FS Date: 4/23/2014

Headwall, pipe, and flapgate visible on WS toe.

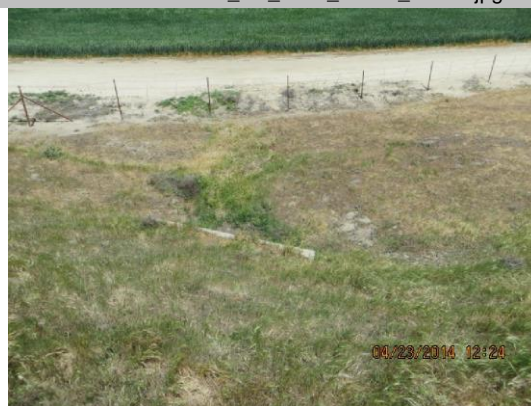
Photo 3 of 3 : UCIP_SP_2019_39883_62560.jpg

Item	DWR UCIP LMA Responsibility			37.087525 °		37.087525 °
				-120.532827 °		-120.532827 °
DWR ID	19787					
Comment Code						
Inspector Comment						
FS_ID:39883						
DS_ID:19787						
EP_NO: N/A						
Repair Type: Non-Urgent						
Crossing Status: Found						
UCIP Comments: 04/23/2014 Dense vegetation limits the inspector's visibility to identify signs of pipe failure (leaks) along the landward slope. Recommend removing vegetation along pipe alignment to conduct proper inspection of structure. (DWR UCIP - W. Wylie)						
FIELD_STRUCT_DESC: 24-inch corrugated metal gravity drainage pipe through the levee, 12.4 feet below the crown. Flap gate on the waterside (WS) end. Concrete headwall on the landside (LS) end. Concrete U-shaped headwall on the WS end. [Additional Reference(s): DWR Levee Log, 2002. USACE San Joaquin O&M Manual 601.1, 1967, (HLM 21.81)].						
FS Date: 4/23/2014

Headwall and pipe visible on LS toe.

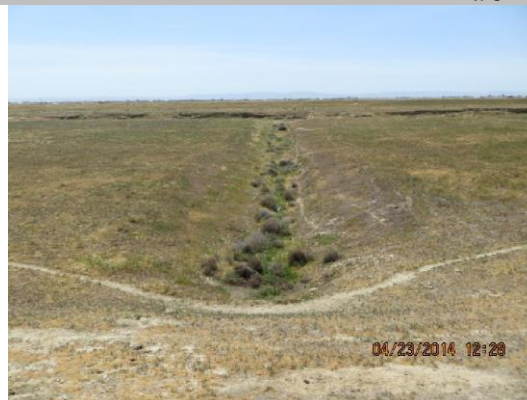
Photo 1 of 3 : UCIP_SP_2019_39610_62586.jpg

Comment Code						
Inspector Comment						
FS_ID:39610						
DS_ID:19788						
EP_NO: N/A						
Repair Type: Non-Urgent						
Crossing Status: Found						
UCIP Comments: 04/23/2014 Dense vegetation limits the inspector's visibility to identify signs of pipe failure (leaks) along the landward slope. Recommend removing vegetation along pipe alignment to conduct proper inspection of structure. (DWR UCIP - W. Wylie)						
FIELD_STRUCT_DESC: 24-inch corrugated metal gravity drainage pipe through the levee, 10.7 feet below the crown. Flap gate on the waterside (WS) end. Concrete headwall on the landside (LS) end. Concrete U-shaped headwall on the WS end. [Additional Reference(s): DWR Levee Log, 2002. USACE San Joaquin O&M Manual 601.1, 1967, (HLM 21.85)].						
FS Date: 4/23/2014

Headwall, pipe, and flapgate visible on WS toe.

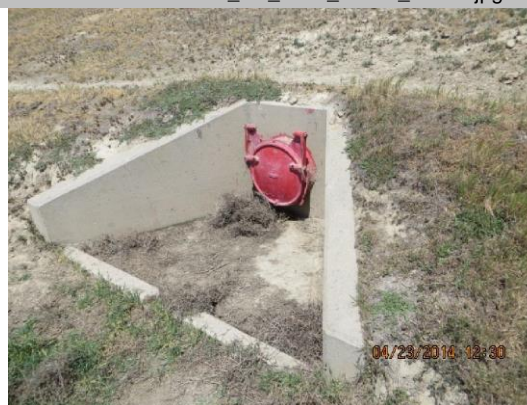
Photo 2 of 3 : UCIP_SP_2019_39610_62588.jpg

Headwall, pipe, and flapgate visible on WS toe.

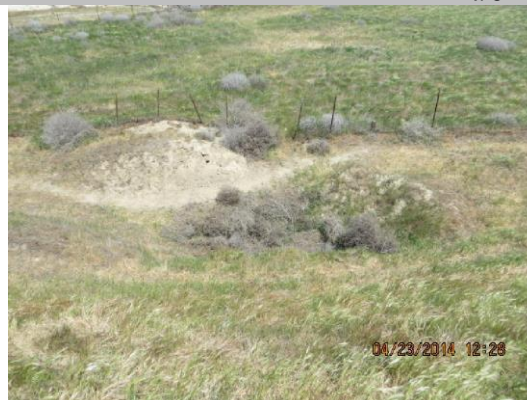
Photo 3 of 3 : UCIP_SP_2019_39610_62587.jpg

Comment Code					
Inspector Comment					
FS_ID:39610 DS_ID:19788 EP_NO: N/A Repair Type: Non-Urgent Crossing Status: Found UCIP Comments: 04/23/2014 Dense vegetation limits the inspector's visibility to identify signs of pipe failure (leaks) along the landward slope. Recommend removing vegetation along pipe alignment to conduct proper inspection of structure. (DWR UCIP - W. Wylie) FIELD_STRUCT_DESC: 24-inch corrugated metal gravity drainage pipe through the levee, 10.7 feet below the crown. Flap gate on the waterside (WS) end. Concrete headwall on the landside (LS) end. Concrete U-shaped headwall on the WS end. [Additional Reference(s): DWR Levee Log, 2002. USACE San Joaquin O&M Manual 601.1, 1967, (HLM 21.85)]. FS Date: 4/23/2014

Headwall and pipe visible on LS toe.

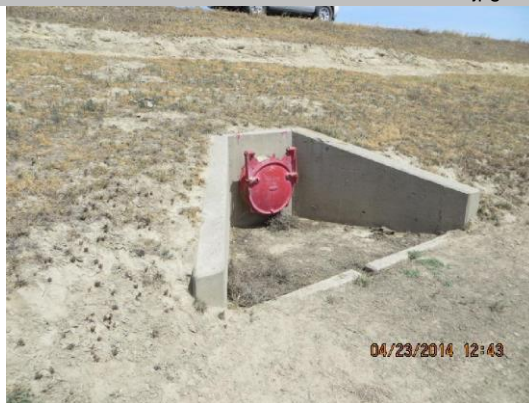
Photo 2 of 3 : UCIP_SP_2019_39611_62593.jpg

Headwall, pipe, and flapgate visible on WS toe.

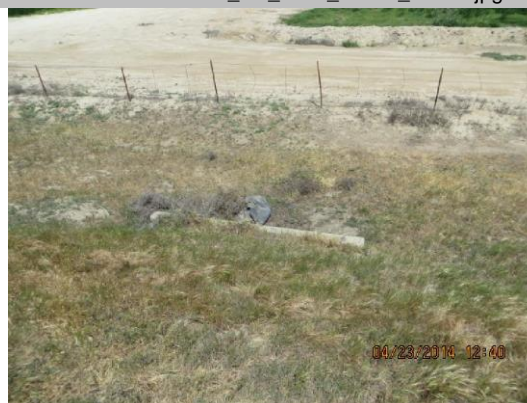
Photo 3 of 3 : UCIP_SP_2019_39611_62592.jpg

Item	DWR UCIP LMA Responsibility			37.083410 °	37.083410 °	
				-120.528356 °	-120.528356 °	
DWR ID	19789					
Comment Code						
Inspector Comment						
FS_ID:39611 DS_ID:19789 EP_NO: N/A Repair Type: Non-Urgent Crossing Status: Found UCIP Comments: 04/23/2014 Dense vegetation limits the inspector's visibility to identify signs of pipe failure (leaks) along the landward slope. Recommend removing vegetation along pipe alignment to conduct proper inspection of structure. Sediment buildup in pipe visible from landward side--recommend contacting owner to clear pipe. (DWR UCIP - W. Wylie) FIELD_STRUCT_DESC: 24-inch corrugated metal gravity drainage pipe through the levee, 10.2 feet below the crown. Flap gate on the waterside (WS) end. Concrete headwall on the landside (LS) end. Concrete U-shaped headwall on the WS end. [Additional Reference(s): DWR Levee Log, 2002. USACE San Joaquin O&M Manual 601.1, 1967, (HLM 22.19)]. FS Date: 4/23/2014

Headwall and pipe visible on LS toe.

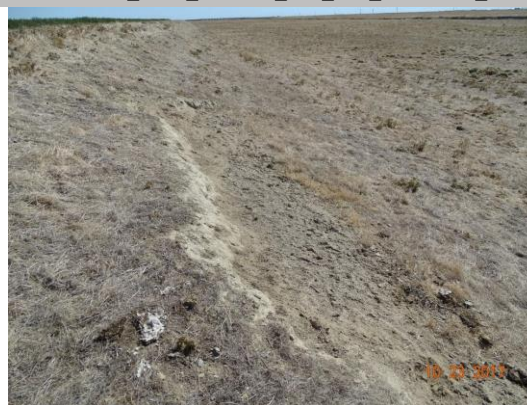
Photo 1 of 1 : SP_2019_NA0010_123_121_20190307_00023.jpg

LM Start	22.35	Rating **	M	Issue No.	121
LM End	22.35	Issue Type +	Ma	Location *	WS
Category	Earthen Levee			GPS Latitude/Longitude	
				Start	End
Item	Erosion / Bank Caving			37.082696 °	37.082696 °
				-120.527620 °	-120.527620 °
DWR ID	DWR_NA0010_05_f_2017_121				
Comment Code					
E1 : Note and monitor erosion site.					
Inspector Comment					
Waterside slope damaged by animal traffic.

Looking southeast at the waterside slope.

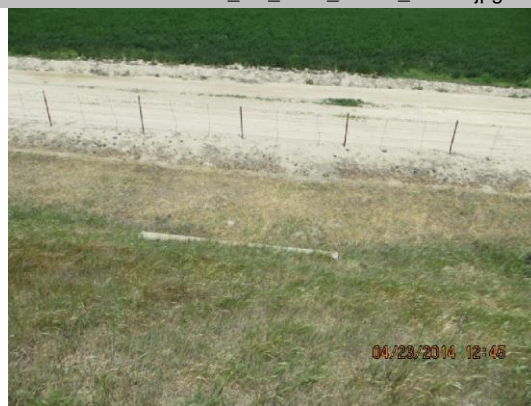
Photo 3 of 3 : UCIP_SP_2019_39613_62597.jpg

Item	DWR UCIP LMA Responsibility			37.080486 °	37.080486 °	
				-120.525180 °	-120.525180 °	
DWR ID	19790					
Comment Code						
Inspector Comment						
FS_ID:39613 DS_ID:19790 EP_NO: N/A Repair Type: Non-Urgent Crossing Status: Found UCIP Comments: 04/23/2014 Dense vegetation limits the inspector's visibility to identify signs of pipe failure (leaks) along the landward slope. Recommend removing vegetation along pipe alignment to conduct proper inspection of structure. Sediment buildup in pipe visible from landward side--recommend contacting owner to clear pipe. (DWR UCIP - W. Wylie) FIELD_STRUCT_DESC: 24-inch corrugated metal gravity drainage pipe through the levee, 10.4 feet below the crown. Flap gate on the waterside (WS) end. Concrete headwall on the landside (LS) end. Concrete U-shaped headwall on the WS end. [Additional Reference(s): DWR Levee Log, 2002. USACE San Joaquin O&M Manual 601.1, 1967, (HLM 22.46)]. FS Date: 4/23/2014

Headwall and pipe visible on LS toe.

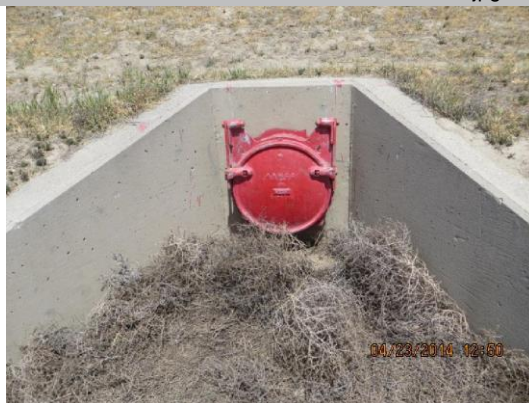
Photo 2 of 3 : UCIP_SP_2019_39616_62600.jpg

Headwall, pipe, and flapgate visible on WS toe.

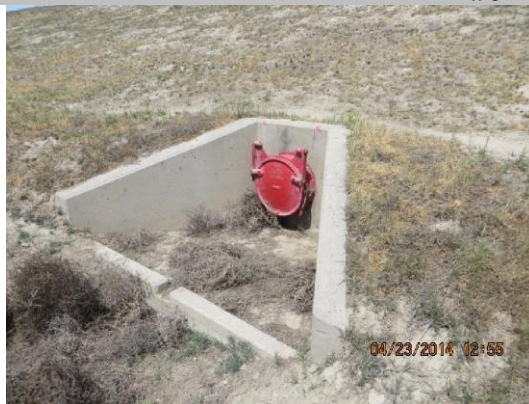
Photo 2 of 3 : UCIP_SP_2019_39617_62608.jpg

Headwall, pipe, and flapgate visible on WS toe.

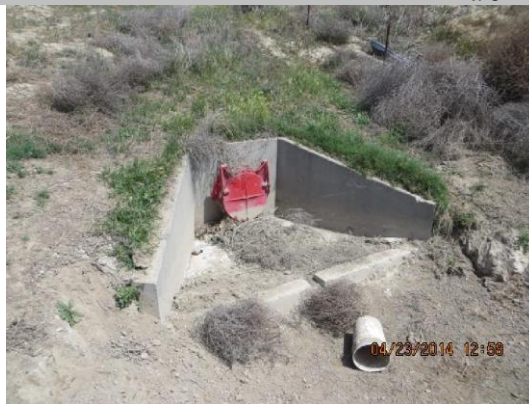
Photo 2 of 3 : UCIP_SP_2019_39618_62610.jpg

Headwall, pipe, and flapgate visible on WS toe.

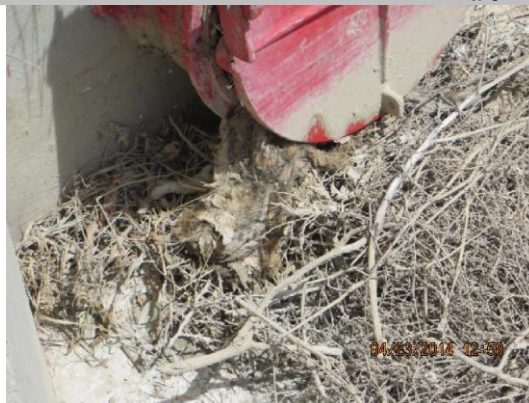
Photo 3 of 3 : UCIP_SP_2019_39618_62615.jpg

Comment Code					
Inspector Comment					
FS_ID:39618					
DS_ID:19793					
EP_NO: N/A					
Repair Type: Non-Urgent					
Crossing Status: Found					
UCIP Comments: 04/23/2014 Debris blocking closure of outlet. Dense vegetation limits the inspector's visibility to identify signs of pipe failure (leaks) along the waterward and landward slopes. Recommend removing vegetation along pipe alignment to conduct proper inspection of structure. (DWR UCIP - W. Wylie)					
FIELD_STRUCT_DESC: 24-inch corrugated metal gravity drainage pipe through the levee, 11.5 feet below the crown. Flap gate on the waterside (WS) end. Concrete headwall on the landside (LS) end. Concrete U-shaped headwall on the WS end. [Additional Reference(s): DWR Levee Log, 2002].					
FS Date: 4/23/2014

Debris blocking closure of outlet on WS toe.

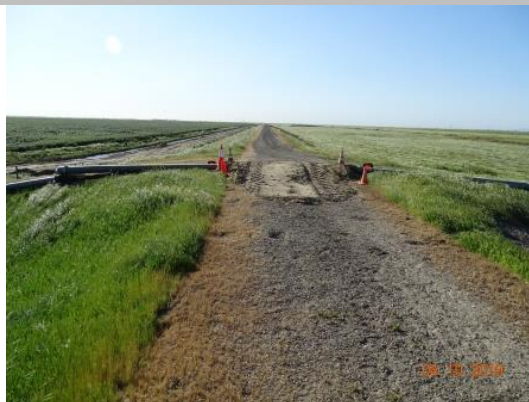
Photo 1 of 3 : SP_2019_NA0010_123_184_20190423_00341.jpg

LM Start	23.23	Rating **	M	Issue No.	184
LM End	23.23	Issue Type +	En	Location *	CR
Category	Earthen Levee			GPS Latitude/Longitude	
				Start	End
Item	Encroachments			37.073259 °	37.073259 °
				-120.516970 °	-120.516970 °
DWR ID	DWR_NA0010_05_s_2019_184				
Comment Code					
PI : Pipe					
Inspector Comment

View of pipe encroachment looking upstream along the levee crown.
(Spring 2019)

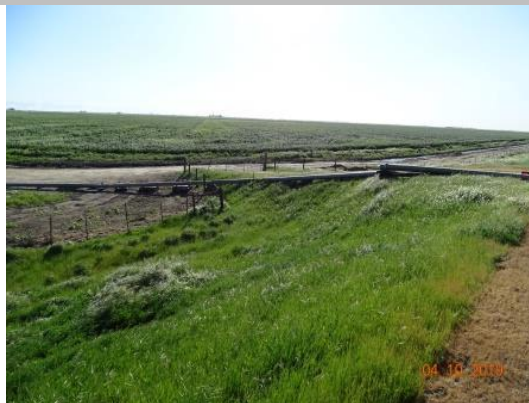
Photo 2 of 3 : SP_2019_NA0010_123_184_20190423_00340.jpg

View of pipe on landside slope. (Spring 2019)

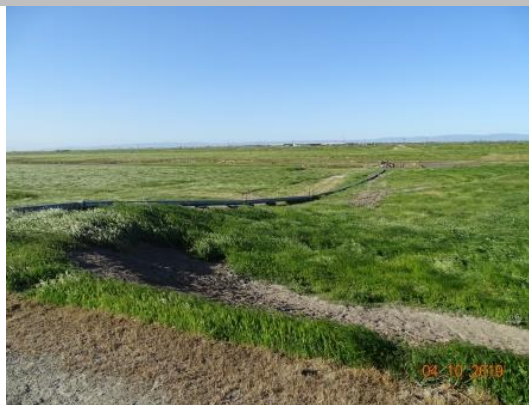
Photo 3 of 3 : SP_2019_NA0010_123_184_20190423_00342.jpg

View of pipe on waterside slope. (Spring 2019)

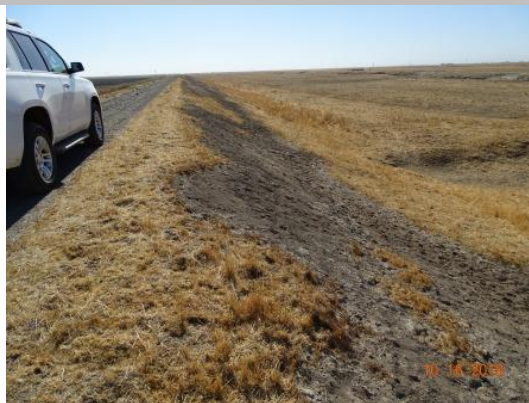
Photo 1 of 1 : SP_2019_NA0010_123_160_20190307_00051.jpg

LM Start	23.24	Rating **	A/W	Issue No.	160
LM End	23.25	Issue Type +	Ma	Location *	WS
Category	Earthen Levee			GPS Latitude/Longitude	
				Start	End
Item	Slope Stability			37.073064 °	37.072946 °
				-120.516771 °	-120.516634 °
DWR ID	DWR_NA0010_05_f_2018_160				
Comment Code					
S2 : Repair the levee slope damaged by foot traffic and prevent access where possible.					
Inspector Comment					
There is slope damage caused by livestock on waterside.

Slope damage cause by livestock foot traffic. (Fall 2018)

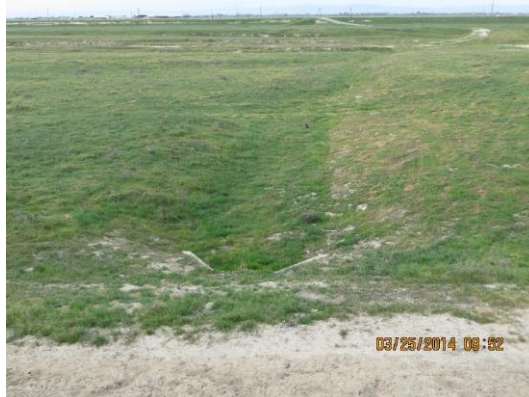
Photo 1 of 3 : UCIP_SP_2019_32763_59262.jpg

LM Start	23.25	Rating **	A/W	Issue No.	1371
LM End	23.25	Issue Type +	Ma	Location *	
Category	Supplemental			GPS Latitude/Longitude	
				Start	End
Item	DWR UCIP LMA Responsibility			37.072989 °	37.072989 °
				-120.516687 °	-120.516687 °
DWR ID	19794				
Comment Code					
Inspector Comment					
FS_ID:32763 DS_ID:19794 EP_NO: N/A Repair Type: No Action Needed Crossing Status: Found UCIP Comments: FIELD_STRUCT_DESC: 30-inch corrugated metal gravity drainage pipe through the levee, 11.6 feet below the crown. Flap gate on the waterside (WS) end. Concrete headwall on the landside (LS) end. Concrete U-shaped headwall on the WS end. [Additional Reference(s): DWR Levee Log, 2002. USACE San Joaquin O&M Manual 601.1, 1967, (HLM 23.15)]. FS Date: 3/25/2014 9:04:45 AM

Concrete headwall on WS toe.

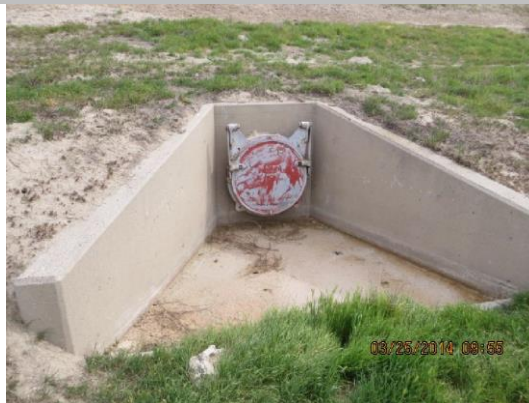
Photo 2 of 3 : UCIP_SP_2019_32763_59263.jpg

Flapgate and concrete headwall on WS toe.

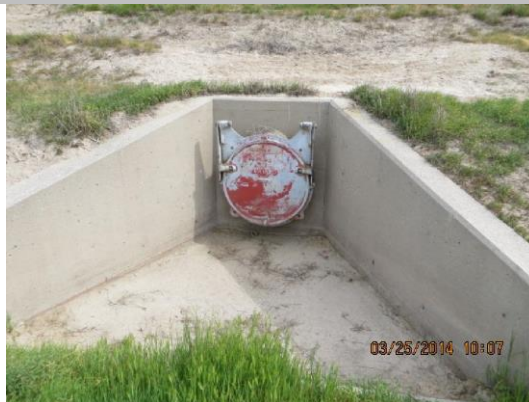
Photo 2 of 3 : UCIP_SP_2019_39621_59270.jpg

Flapgate on Concrete headwall on WS toe.

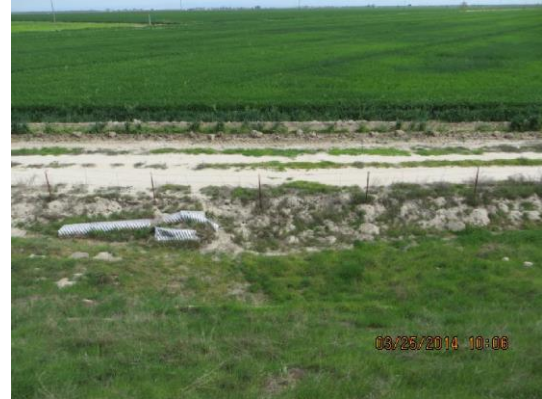
Photo 3 of 3 : UCIP_SP_2019_39621_59271.jpg

LM Start	23.72	Rating **	M	Issue No.	1372 (cont)
LM End	23.72	Issue Type +	Ma	Location *	
Category	Supplemental			GPS Latitude/Longitude	
				Start	End
Item	DWR UCIP LMA Responsibility			37.067799 °	37.067799 °
				-120.511093 °	-120.511093 °
DWR ID	19796				
Comment Code					
Inspector Comment					
FS_ID:39621 DS_ID:19796 EP_NO: N/A Repair Type: Non-Urgent Crossing Status: Found UCIP Comments: 03/25/2014 Sediment buildup in pipe visible from landward side--recommend contacting owner to clear pipe. (DWR UCIP - W. Wylie) FIELD_STRUCT_DESC: 30-inch corrugated metal gravity drainage pipe through the levee, 12.1 feet below the crown. Flap gate on the waterside (WS) end. Concrete U-shaped headwall on the WS end. [Additional Reference(s): DWR Levee Log, 2002. USACE San Joaquin O&M Manual 601.1, 1967, (HLM 23.62)]. FS Date: 3/25/2014

Concrete headwall on LS toe.

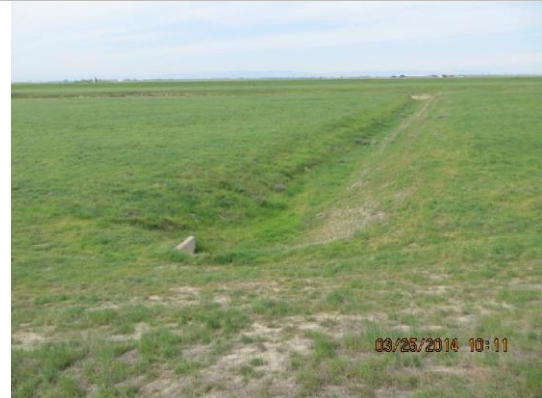
Photo 1 of 3 : UCIP_SP_2019_39620_59282.jpg

Comment Code						
Inspector Comment						
FS_ID:39620 DS_ID:19797 EP_NO: N/A Repair Type: Non-Urgent Crossing Status: Found UCIP Comments: 03/25/2014 Minor sediment/debris buildup in pipe visible from landward side--recommend contacting owner to clear pipe. (DWR UCIP - W. Wylie) FIELD_STRUCT_DESC: 36-inch corrugated metal gravity drainage pipe through the levee, 12.1 feet below the crown. Flap gate on the waterside (WS) end. Concrete headwall on the landside (LS) end. Concrete U-shaped headwall on the WS end. [Additional Reference(s): DWR Levee Log, 2002. USACE San Joaquin O&M Manual 601.1, 1967, (HLM 23.85)]. FS Date: 3/25/2014

Concrete headwall on WS toe.

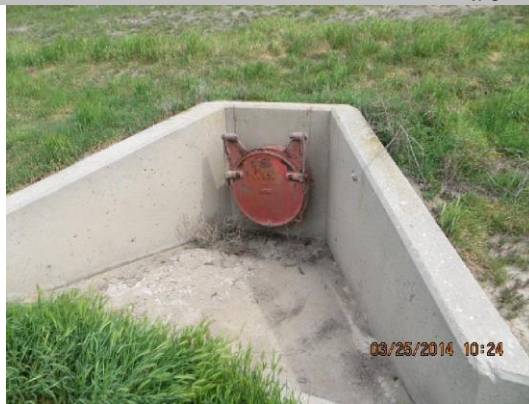
Photo 2 of 3 : UCIP_SP_2019_46850_59285.jpg

Flapgate at concrete headwall at WS toe.

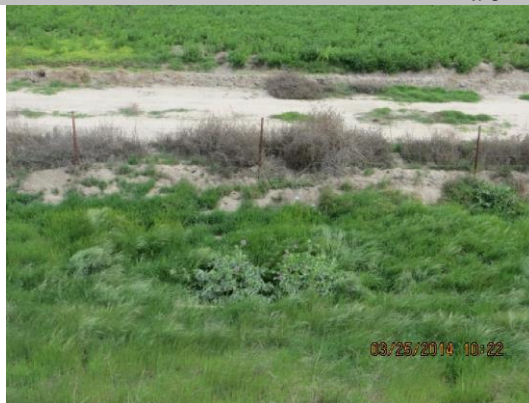
Photo 3 of 3 : UCIP_SP_2019_46850_59286.jpg

Item	DWR UCIP LMA Responsibility			37.061724 °	37.061724 °	
				-120.504512 °	-120.504512 °	
DWR ID	19798					
Comment Code						
Inspector Comment						
FS_ID:46850 DS_ID:19798 EP_NO: N/A Repair Type: Non-Urgent Crossing Status: Found UCIP Comments: 03/25/2014 Dense vegetation limits the inspector's visibility to identify signs of pipe failure (leaks) along the landward slope. Recommend removing vegetation along pipe alignment to conduct proper inspection of structure. (DWR UCIP - W. Wylie) FIELD_STRUCT_DESC: 24-inch corrugated metal gravity drainage pipe through the levee, 11.2 feet below the crown. Flap gate on the waterside (WS) end. Concrete headwall on the landside (LS) end. Concrete U-shaped headwall on the WS end. [Additional Reference(s): DWR Levee Log, 2002. USACE San Joaquin O&M Manual 601.1, 1967, (HLM 24.18)]. FS Date: 3/25/2014

Concrete headwall at LS toe.

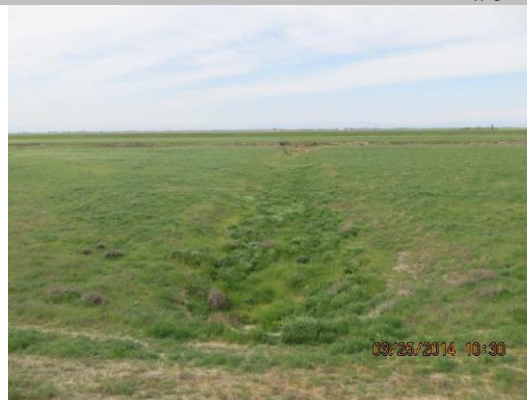
Photo 1 of 3 : UCIP_SP_2019_39623_59292.jpg

Comment Code					
Inspector Comment					
FS_ID:39623 DS_ID:19799 EP_NO: N/A Repair Type: Non-Urgent Crossing Status: Found UCIP Comments: 03/25/2014 Dense vegetation limits the inspector's visibility to identify signs of pipe failure (leaks) along the landward slope. Recommend removing vegetation along pipe alignment to conduct proper inspection of structure. (DWR UCIP - W. Wylie) FIELD_STRUCT_DESC: 24-inch corrugated metal gravity drainage pipe through the levee, 11.2 feet below the crown. Flap gate on the waterside (WS) end. Concrete headwall on the landside (LS) end. Concrete U-shaped headwall on the WS end. [Additional Reference(s): DWR Levee Log, 2002. USACE San Joaquin O&M Manual 601.1, 1967, (HLM 24.46)]. FS Date: 3/25/2014

Concrete headwall on WS toe.

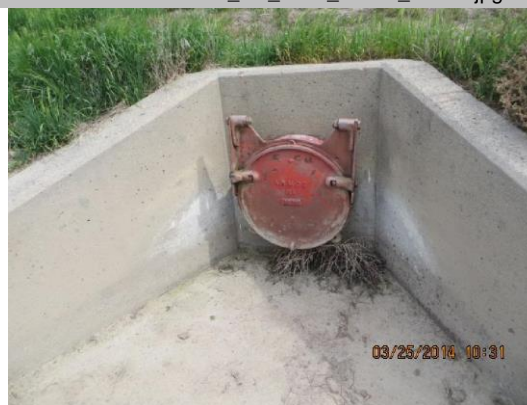
Photo 2 of 3 : UCIP_SP_2019_39623_59290.jpg

Flapgate at Concrete headwall on WS toe.

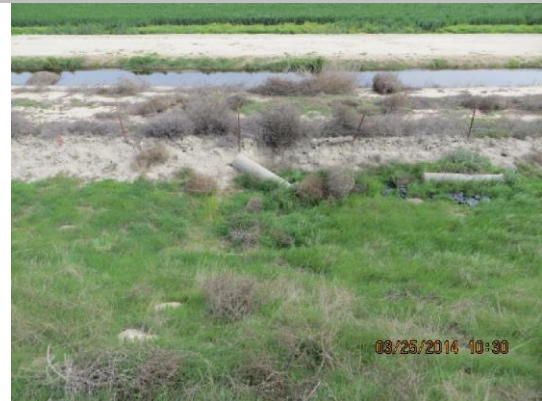
Photo 3 of 3 : UCIP_SP_2019_39623_59291.jpg

Item	DWR UCIP LMA Responsibility			37.058673 °	37.058673 °	
				-120.501238 °	-120.501238 °	
DWR ID	19799					
Comment Code						
Inspector Comment						
FS_ID:39623						
DS_ID:19799						
EP_NO: N/A						
Repair Type: Non-Urgent						
Crossing Status: Found						
UCIP Comments: 03/25/2014 Dense vegetation limits the inspector's visibility to identify signs of pipe failure (leaks) along the landward slope.						
Recommend removing vegetation along pipe alignment to conduct proper inspection of structure. (DWR UCIP - W. Wylie)						
FIELD_STRUCT_DESC: 24-inch corrugated metal gravity drainage pipe through the levee, 11.2 feet below the crown. Flap gate on the waterside (WS) end. Concrete headwall on the landside (LS) end.						
Concrete U-shaped headwall on the WS end. [Additional Reference(s): DWR Levee Log, 2002. USACE San Joaquin O&M Manual 601.1, 1967, (HLM 24.46)].						
FS Date: 3/25/2014

Concrete headwall on LS toe.

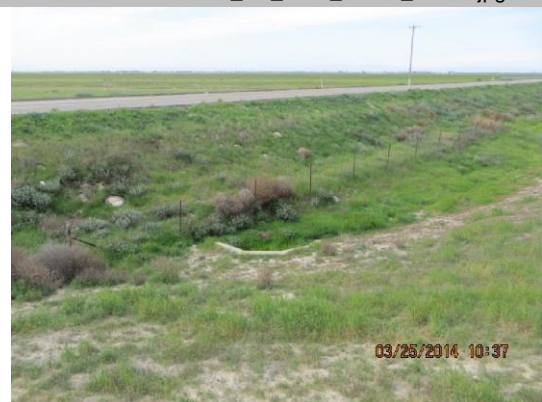
Photo 1 of 3 : UCIP_SP_2019_32786_59297.jpg

LM Start	24.93	Rating **	A/W	Issue No.	1376
LM End	24.93	Issue Type +	Ma	Location *	
Category	Supplemental			GPS Latitude/Longitude	
				Start	End
Item	DWR UCIP LMA Responsibility			37.054481 °	37.054481 °
				-120.496798 °	-120.496798 °
DWR ID	19800				
Comment Code					
Inspector Comment					
FS_ID:32786 DS_ID:19800 EP_NO: N/A Repair Type: No Action Needed Crossing Status: Found UCIP Comments: FIELD_STRUCT_DESC: 24-inch corrugated metal gravity drainage pipe through the levee, 10.7 feet below the crown. Flap gate on the waterside (WS) end. Concrete headwall on the landside (LS) end. Concrete U-shaped headwall on the WS end. [Additional Reference(s): DWR Levee Log, 2002. USACE San Joaquin O&M Manual 601.1, 1967, (HLM 24.82)]. FS Date: 3/25/2014

Concrete headwall on WS toe.

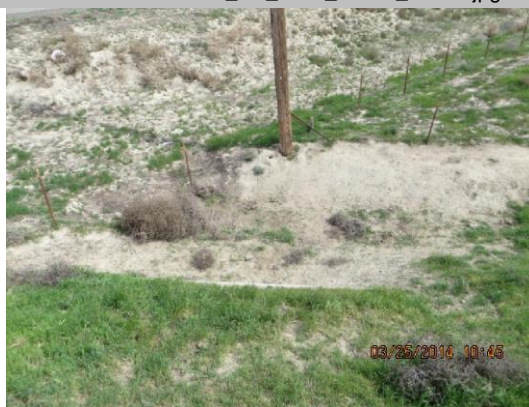
Photo 2 of 3 : UCIP_SP_2019_39624_59301.jpg

Concrete headwall on LS toe.

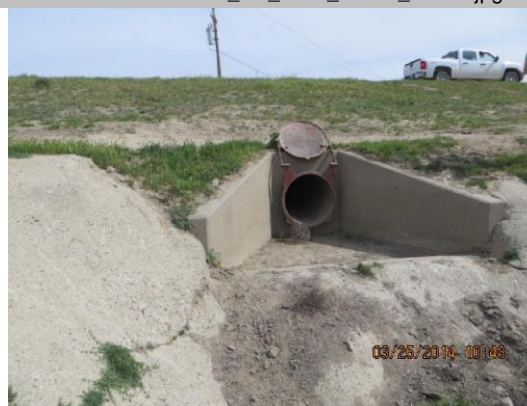
Photo 3 of 3 : UCIP_SP_2019_39624_59303.jpg

LM Start	24.96	Rating **	A/W	Issue No.	1377 (cont)	
LM End	24.96	Issue Type +	Ma	Location *		
Category	Supplemental			GPS Latitude/Longitude		
				Start		End
Item	DWR UCIP LMA Responsibility			37.054344 °		37.054344 °
				-120.496214 °		-120.496214 °
DWR ID	19801					
Comment Code						
Inspector Comment						
FS_ID:39624 DS_ID:19801 EP_NO: N/A Repair Type: No Action Needed Crossing Status: Found UCIP Comments: FIELD_STRUCT_DESC: 30-inch corrugated metal gravity drainage pipe through the levee, 10.9 feet below the crown. Flap gate on the waterside (WS) end. Concrete headwall on the landside (LS) end. Concrete U-shaped headwall on the WS end. [Additional Reference(s): DWR Levee Log, 2002. USACE San Joaquin O&M Manual 601.1, 1967, (HLM 24.87)]. FS Date: 3/25/2014

Flapgate on headwall at WS toe.

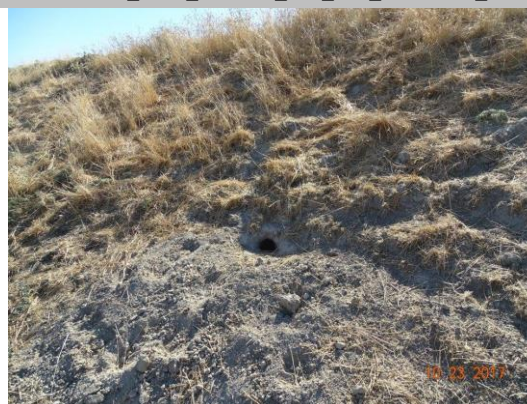
Photo 1 of 1 : SP_2019_NA0010_123_123_20190307_00024.jpg

LM Start	24.98	Rating **	M	Issue No.	123
LM End	25.26	Issue Type +	Ma	Location *	LS
Category	Earthen Levee			GPS Latitude/Longitude	
				Start	End
Item	Animal Control			37.054150 °	37.051252 °
				-120.495964 °	-120.492368 °
DWR ID	DWR_NA0010_05_f_2017_123				
Comment Code					
A3 : No rodents visible, but rodent burrows visible; need to backfill and compact or grout burrows.					
Inspector Comment

Looking southwest at the landside slope.

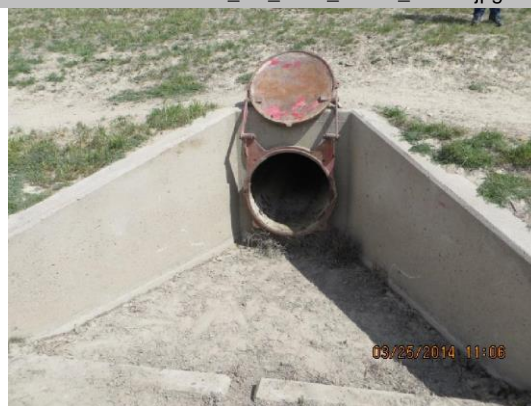
Photo 2 of 3 : UCIP_SP_2019_32789_59312.jpg

LM Start	25.24	Rating **	M	Issue No.	1379 (cont)
LM End	25.24	Issue Type +	Ma	Location *	
Category	Supplemental			GPS Latitude/Longitude	
				Start	End
Item	DWR UCIP LMA Responsibility			37.051477 °	37.051477 °
				-120.492650 °	-120.492650 °
DWR ID	19803				
Comment Code					
Inspector Comment					
FS_ID:32789 DS_ID:19803 EP_NO: N/A Repair Type: Non-Urgent Crossing Status: Found UCIP Comments: 03/25/2014 Flapgate propped open during flood season. (DWR UCIP - W. Wylie) FIELD_STRUCT_DESC: 30-inch corrugated metal gravity drainage pipe through the levee, 11.3 feet below the crown. Flap gate on the waterside (WS) end. Concrete headwall on the landside (LS) end. Concrete U-shaped headwall on the WS end. [Additional Reference(s): DWR Levee Log, 2002. USACE San Joaquin O&M Manual 601.1, 1967, (HLM 25.43)]. FS Date: 3/25/2014

Concrete headwall and flapgate on WS toe.
