**Flood Control Project Maintenance
Levee Inspections**
LMA District Cover Sheet
Spring 2019 Levee Inspection Results

Lower San Joaquin Levee District

Spring 2019 Levee Inspection Results

Waterway			Bank	Unit Miles
Unit No. 01 San Joaquin River			Right	22.52
	Spring (March - May)	Summer (June - August)	(September - November) Fall	Winter (December - February)
Unit Maintenance Rating (Fall Only)				
Date of Inspection	3/26/2019 - 3/26/2019			
DWR Inspector	Corey Fujitani			
Accompanied By

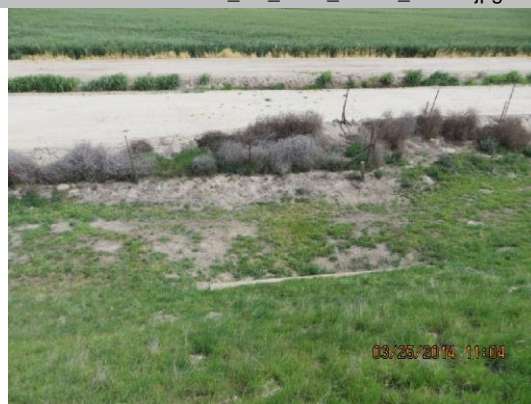
Photo 3 of 3 : UCIP_SP_2019_32789_59310.jpg

Concrete headwall on LS toe.

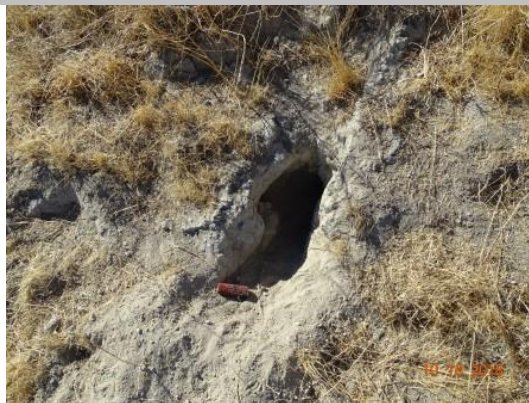
Photo 1 of 1 : SP_2019_NA0010_123_9_20190307_00006.jpg

LM Start	25.28	Rating **	M	Issue No.	9
LM End	25.64	Issue Type +	Ma	Location *	LS
Category	Earthen Levee			GPS Latitude/Longitude	
				Start	End
Item	Animal Control			37.051076 °	37.047042 °
				-120.492153 °	-120.488092 °
DWR ID	DWR_NA0010_05_s_2012_9				
Comment Code					
A3 : No rodents visible, but rodent burrows visible; need to backfill and compact or grout burrows.					
Inspector Comment					
Several rodent holes are noted along this section.

View of representative rodent burrow. (Fall 2018)

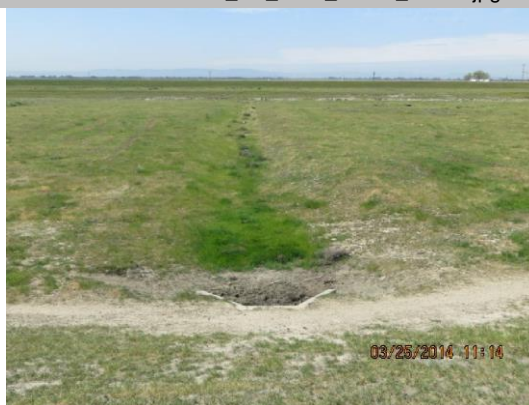
Photo 1 of 3 : UCIP_SP_2019_39625_59316.jpg

LM Start	25.61	Rating **	M	Issue No.	1380
LM End	25.61	Issue Type +	Ma	Location *	
Category	Supplemental			GPS Latitude/Longitude	
				Start	End
Item	DWR UCIP LMA Responsibility			37.047455 °	37.047455 °
				-120.488443 °	-120.488443 °
DWR ID	19804

Comment Code					
Inspector Comment					
FS_ID:39625 DS_ID:19804 EP_NO: N/A Repair Type: Non-Urgent Crossing Status: Found UCIP Comments: 03/25/2014 Dense vegetation limits the inspector's visibility to identify signs of pipe failure (leaks) along the landward slope. Recommend removing vegetation along pipe alignment to conduct proper inspection of structure. Sediment buildup in pipe visible from landward side--recommend contacting owner to clear pipe. (DWR UCIP - W. Wylie) FIELD_STRUCT_DESC: 30-inch corrugated metal gravity drainage pipe through the levee, 12 feet below the crown. Flap gate on the waterside (WS) end. Concrete headwall on the landside (LS) end. Concrete U-shaped headwall on the WS end. [Additional Reference(s): DWR Levee Log, 2002. USACE San Joaquin O&M Manual 601.1, 1967, (HLM 25.51)]. FS Date: 3/25/2014

Concrete headwall on WS toe.

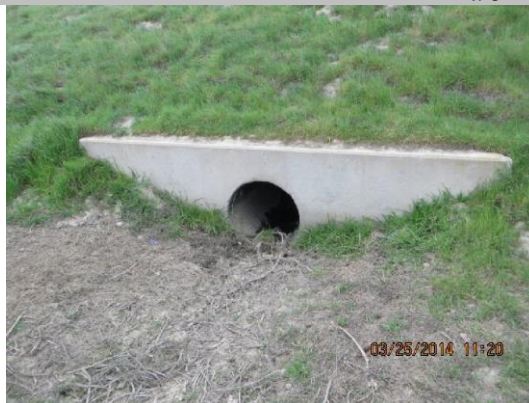
Photo 2 of 3 : UCIP_SP_2019_39626_59320.jpg

LM Start	25.63	Rating **	M	Issue No.	1381 (cont)	
LM End	25.63	Issue Type +	Ma	Location *		
Category	Supplemental			GPS Latitude/Longitude		
				Start		End
Item	DWR UCIP LMA Responsibility			37.047170 °		37.047170 °
				-120.488222 °		-120.488222 °
DWR ID	19805					
Comment Code						
Inspector Comment						
FS_ID:39626 DS_ID:19805 EP_NO: N/A Repair Type: Non-Urgent Crossing Status: Found UCIP Comments: 03/25/2014 Sediment buildup in pipe visible from landward side--recommend contacting owner to clear pipe. (DWR UCIP - W. Wylie) FIELD_STRUCT_DESC: 30-inch corrugated metal gravity drainage pipe through the levee, 12.1 feet below the crown. Flap gate on the waterside (WS) end. Concrete headwall on the landside (LS) end. Concrete U-shaped headwall on the WS end. [Additional Reference(s): DWR Levee Log, 2002. USACE San Joaquin O&M Manual 601.1, 1967, (HLM 25.53)]. FS Date: 3/25/2014

Concrete headwall on LS toe.

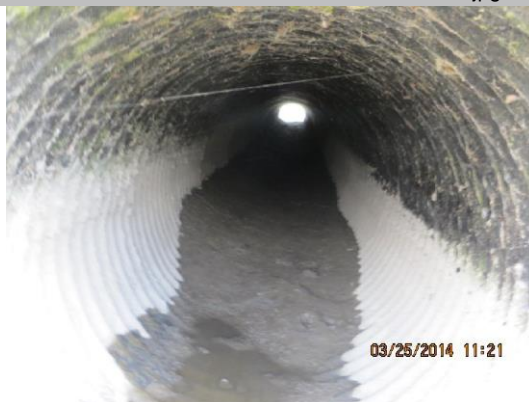
Photo 3 of 3 : UCIP_SP_2019_39626_59319.jpg

LM Start	25.63	Rating **	M	Issue No.	1381 (cont)
LM End	25.63	Issue Type +	Ma	Location *

Inside pipe on LS toe.

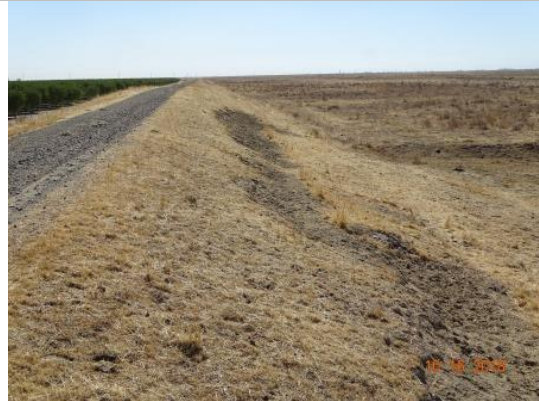
Photo 1 of 1 : SP_2019_NA0010_123_161_20190307_00052.jpg

LM Start	26.19	Rating **	M	Issue No.	161
LM End	26.21	Issue Type +	Ma	Location *	WS
Category	Earthen Levee			GPS Latitude/Longitude	
				Start	End
Item	Slope Stability			37.040289 °	37.040043 °
				-120.482988 °	-120.482795 °
DWR ID	DWR_NA0010_05_f _ 2018_161				
Comment Code					
S2 : Repair the levee slope damaged by foot traffic and prevent access where possible.					
Inspector Comment					
Waterside slope damage is caused by livestock foot traffic.

Slope damage on waterside. (Fall 2018)

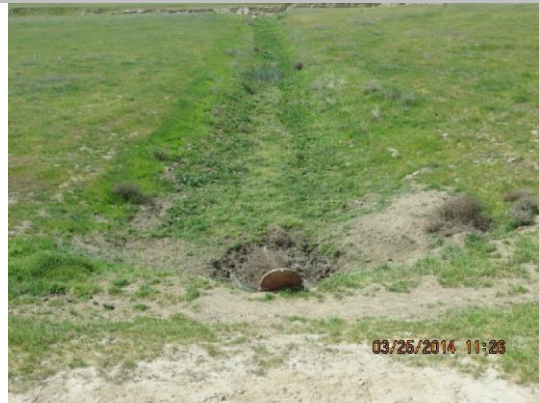
Photo 1 of 3 : UCIP_SP_2019_39627_59341.jpg

LM Start	26.20	Rating **	M	Issue No.	1382	
LM End	26.20	Issue Type +	Ma	Location *		
Category	Supplemental			GPS Latitude/Longitude		
				Start		End
Item	DWR UCIP LMA Responsibility			37.040070 °		37.040070 °
				-120.482796 °		-120.482796 °
DWR ID	19806

Comment Code						
Inspector Comment						
FS_ID:39627						
DS_ID:19806						
EP_NO: N/A						
Repair Type: Non-Urgent						
Crossing Status: Found						
UCIP Comments: 03/25/2014 Sediment buildup in pipe visible from landward side--recommend contacting owner to clear pipe. (DWR UCIP - W. Wylie)						
FIELD_STRUCT_DESC: 24-inch corrugated metal gravity drainage pipe through the levee, 10 feet below the crown. Flap gate on the waterside (WS) end. Concrete headwall on the landside (LS) end. Concrete U-shaped headwall on the WS end. [Additional Reference(s): DWR Levee Log, 2002. USACE San Joaquin O&M Manual 601.1, 1967, (HLM 26.11)].						
FS Date: 3/25/2014

Concrete headwall on WS toe.

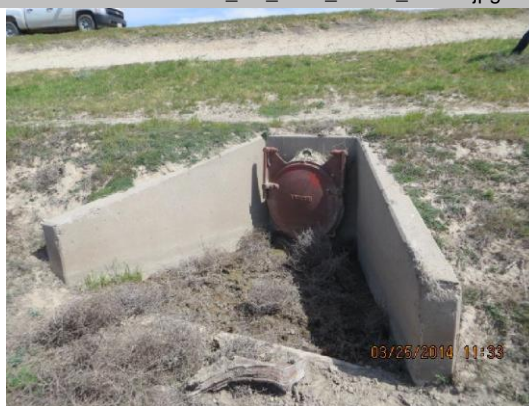
Photo 3 of 3 : UCIP_SP_2019_32804_59345.jpg

LM Start	26.39	Rating **	A/W	Issue No.	1383 (cont)	
LM End	26.39	Issue Type +	Ma	Location *		
Category	Supplemental			GPS Latitude/Longitude		
				Start		End
Item	DWR UCIP LMA Responsibility			37.037772 °		37.037772 °
				-120.481028 °		-120.481028 °
DWR ID	19807					
Comment Code						
Inspector Comment						
FS_ID:32804 DS_ID:19807 EP_NO: N/A Repair Type: No Action Needed Crossing Status: Found UCIP Comments: FIELD_STRUCT_DESC: 36-inch corrugated metal gravity drainage pipe through the levee, 13 feet below the crown. Flap gate on the waterside (WS) end. Concrete headwall on the landside (LS) end. Concrete U-shaped headwall on the WS end. [Additional Reference(s): DWR Levee Log, 2002. USACE San Joaquin O&M Manual 601.1, 1967, (HLM 26.29)]. FS Date: 3/25/2014

Flapgate on Concrete headwall at WS toe.

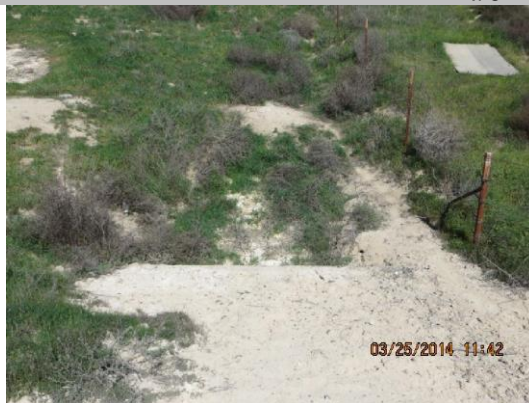
Photo 1 of 3 : UCIP_SP_2019_39628_59350.jpg

LM Start	26.95	Rating **	M	Issue No.	1384
LM End	26.95	Issue Type +	Ma	Location *	
Category	Supplemental			GPS Latitude/Longitude	
				Start	End
Item	DWR UCIP LMA Responsibility			37.032669 °	37.032669 °
				-120.473901 °	-120.473901 °
DWR ID	19808				
Comment Code					
Inspector Comment					
FS_ID:39628 DS_ID:19808 EP_NO: N/A Repair Type: Non-Urgent Crossing Status: Found UCIP Comments: 03/25/2014 Pipe has heavy silt buildup visible from landward side--recommend contacting owner to clear pipe. (DWR UCIP - W. Wylie) FIELD_STRUCT_DESC: 24-inch corrugated metal gravity drainage pipe through the levee, 11.4 feet below the crown. Flap gate on the waterside (WS) end. Concrete headwall on the landside (LS) end. Concrete U-shaped headwall on the WS end. [Additional Reference(s): DWR Levee Log, 2002. USACE San Joaquin O&M Manual 601.1, 1967, (HLM 26.85)]. FS Date: 3/25/2014

Concrete headwall on LS toe.

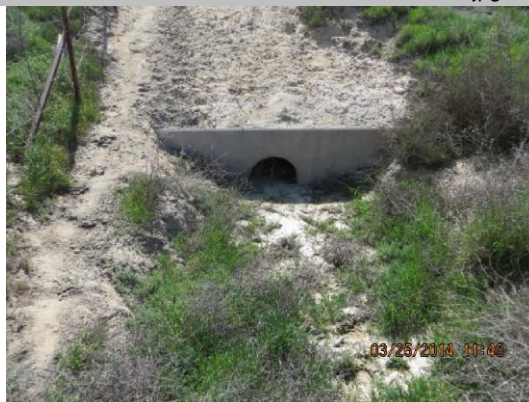
Photo 2 of 3 : UCIP_SP_2019_39628_59349.jpg

LM Start	26.95	Rating **	M	Issue No.	1384 (cont)
LM End	26.95	Issue Type +	Ma	Location *

Concrete headwall on LS toe.

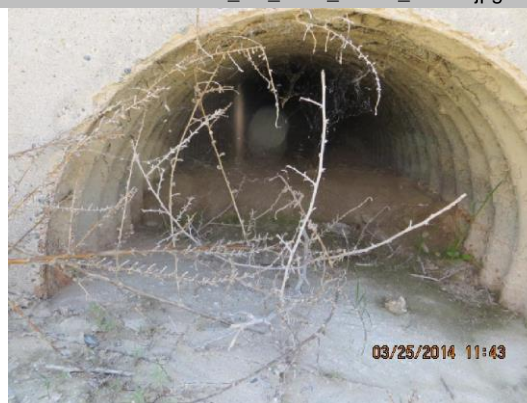
Photo 3 of 3 : UCIP_SP_2019_39628_59348.jpg

LM Start	26.95	Rating **	M	Issue No.	1384 (cont)
LM End	26.95	Issue Type +	Ma	Location *	
Category	Supplemental			GPS Latitude/Longitude	
				Start	End
Item	DWR UCIP LMA Responsibility			37.032669 °	37.032669 °
				-120.473901 °	-120.473901 °
DWR ID	19808				
Comment Code					
Inspector Comment					
FS_ID:39628 DS_ID:19808 EP_NO: N/A Repair Type: Non-Urgent Crossing Status: Found UCIP Comments: 03/25/2014 Pipe has heavy silt buildup visible from landward side--recommend contacting owner to clear pipe. (DWR UCIP - W. Wylie) FIELD_STRUCT_DESC: 24-inch corrugated metal gravity drainage pipe through the levee, 11.4 feet below the crown. Flap gate on the waterside (WS) end. Concrete headwall on the landside (LS) end. Concrete U-shaped headwall on the WS end. [Additional Reference(s): DWR Levee Log, 2002. USACE San Joaquin O&M Manual 601.1, 1967, (HLM 26.85)]. FS Date: 3/25/2014

Silt buildup in pipe at LS toe.

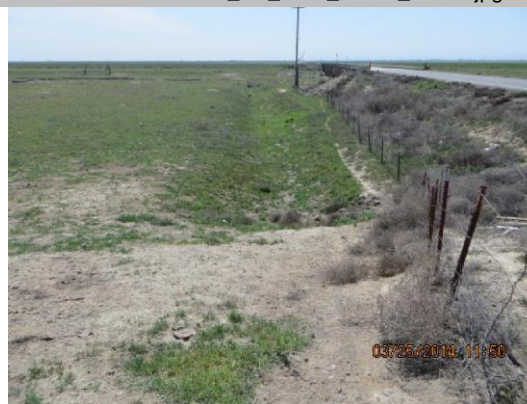
Photo 1 of 3 : UCIP_SP_2019_32806_59353.jpg

LM Start	26.97	Rating **	M	Issue No.	1385
LM End	26.97	Issue Type +	Ma	Location *	
Category	Supplemental			GPS Latitude/Longitude	
				Start	End
Item	DWR UCIP LMA Responsibility			37.032680 °	37.032680 °
				-120.473454 °	-120.473454 °
DWR ID	19748				
Comment Code					
Inspector Comment					
FS_ID:32806 DS_ID:19748 EP_NO: N/A Repair Type: Non-Urgent Crossing Status: Found UCIP Comments: 03/25/2014 Tumble weed buildup at inlet mat create blockage and should be removed. (DWR UCIP - W. Wylie) FIELD_STRUCT_DESC: 24-inch corrugated metal gravity drainage pipe through the levee, 11.3 feet below the crown. Flap gate on the waterside (WS) end. Concrete headwall on the landside (LS) end. Concrete U-shaped headwall on the WS end. [Additional Reference(s): DWR Levee Log, 2002. USACE San Joaquin O&M Manual 601.1, 1967, (HLM 26.87)]. FS Date: 3/25/2014

Concrete headwall at WS toe.

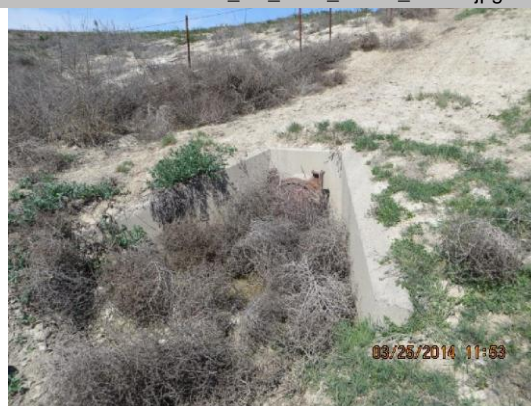
Photo 2 of 3 : UCIP_SP_2019_32806_59355.jpg

LM Start	26.97	Rating **	M	Issue No.	1385 (cont)
LM End	26.97	Issue Type +	Ma	Location *

Flapgate and Concrete headwall at WS toe.

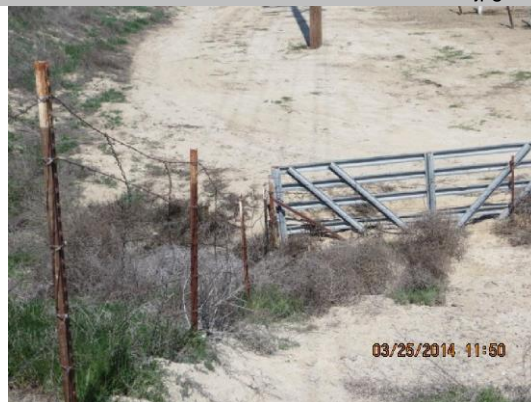
Photo 3 of 3 : UCIP_SP_2019_32806_59354.jpg

LM Start	26.97	Rating **	M	Issue No.	1385 (cont)	
LM End	26.97	Issue Type +	Ma	Location *		
Category	Supplemental			GPS Latitude/Longitude		
				Start		End
Item	DWR UCIP LMA Responsibility			37.032680 °		37.032680 °
				-120.473454 °		-120.473454 °
DWR ID	19748					
Comment Code						
Inspector Comment						
FS_ID:32806 DS_ID:19748 EP_NO: N/A Repair Type: Non-Urgent Crossing Status: Found UCIP Comments: 03/25/2014 Tumble weed buildup at inlet mat create blockage and should be removed. (DWR UCIP - W. Wylie) FIELD_STRUCT_DESC: 24-inch corrugated metal gravity drainage pipe through the levee, 11.3 feet below the crown. Flap gate on the waterside (WS) end. Concrete headwall on the landside (LS) end. Concrete U-shaped headwall on the WS end. [Additional Reference(s): DWR Levee Log, 2002. USACE San Joaquin O&M Manual 601.1, 1967, (HLM 26.87)]. FS Date: 3/25/2014

Concrete headwall at LS toe.

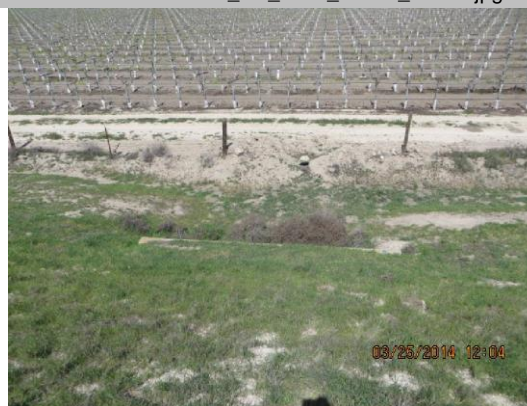
Photo 3 of 3 : UCIP_SP_2019_32807_59357.jpg

LM Start	27.31	Rating **	A/W	Issue No.	1386 (cont)	
LM End	27.31	Issue Type +	Ma	Location *		
Category	Supplemental			GPS Latitude/Longitude		
				Start	End	
Item	DWR UCIP LMA Responsibility			37.032668 °	37.032668 °	
				-120.467299 °	-120.467299 °	
DWR ID	19749					
Comment Code						
Inspector Comment						
FS_ID:32807 DS_ID:19749 EP_NO: N/A Repair Type: No Action Needed Crossing Status: Found UCIP Comments: FIELD_STRUCT_DESC: 36-inch corrugated metal gravity drainage pipe through the levee, 12 feet below the crown. Flap gate on the waterside (WS) end. Concrete headwall on the landside (LS) end. Concrete U-shaped headwall on the WS end. [Additional Reference(s): DWR Levee Log, 2002. USACE San Joaquin O&M Manual 601.1, 1967, (HLM 27.22)]. FS Date: 3/25/2014

Concrete headwall on LS toe.

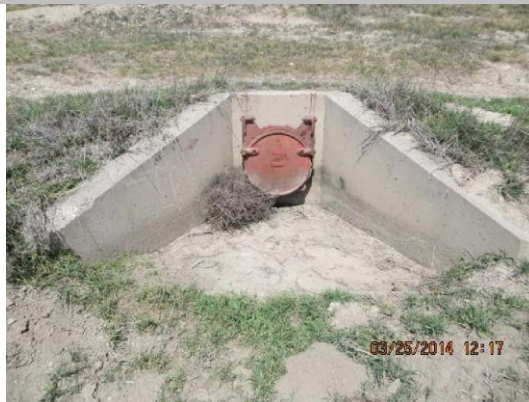
Photo 2 of 3 : UCIP_SP_2019_32823_59383.jpg

LM Start	28.27	Rating **	M	Issue No.	1387 (cont)
LM End	28.27	Issue Type +	Ma	Location *

Flapgate on Concrete headwall at WS toe.

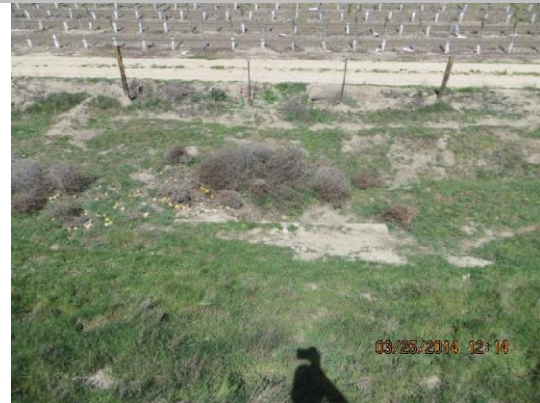
Photo 3 of 3 : UCIP_SP_2019_32823_59381.jpg

LM Start	28.27	Rating **	M	Issue No.	1387 (cont)
LM End	28.27	Issue Type +	Ma	Location *	
Category	Supplemental			GPS Latitude/Longitude	
				Start	End
Item	DWR UCIP LMA Responsibility			37.032623 °	37.032623 °
				-120.450108 °	-120.450108 °
DWR ID	19750				
Comment Code					
Inspector Comment					
FS_ID:32823 DS_ID:19750 EP_NO: N/A Repair Type: Non-Urgent Crossing Status: Found UCIP Comments: 03/25/2014 Animal Burrowing activity at LS toe may undermine headwall. (DWR UCIP - W. Wylie) FIELD_STRUCT_DESC: 24-inch corrugated metal gravity drainage pipe through the levee, 10.8 feet below the crown. Flap gate on the waterside (WS) end. Concrete headwall on the landside (LS) end. Concrete U-shaped headwall on the WS end. [Additional Reference(s): DWR Levee Log, 2002. USACE San Joaquin O&M Manual 601.1, 1967, (HLM 28.17)]. FS Date: 3/25/2014

Concrete headwall on LS toe.

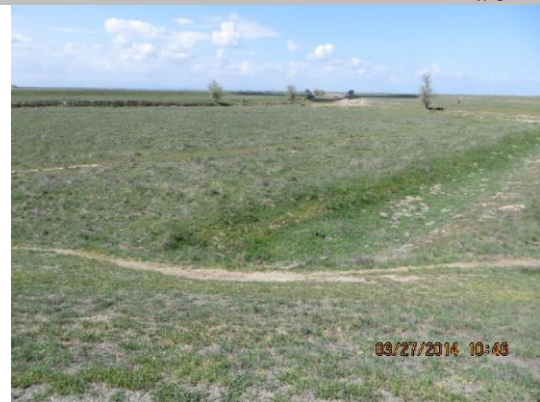
Photo 1 of 3 : UCIP_SP_2019_32832_59420.jpg

LM Start	28.79	Rating **	A/W	Issue No.	1388
LM End	28.79	Issue Type +	Ma	Location *	
Category	Supplemental			GPS Latitude/Longitude	
				Start	End
Item	DWR UCIP LMA Responsibility			37.031640 °	37.031640 °
				-120.441389 °	-120.441389 °
DWR ID	19751				
Comment Code					
Inspector Comment					
FS_ID:32832 DS_ID:19751 EP_NO: N/A Repair Type: No Action Needed Crossing Status: Found UCIP Comments: FIELD_STRUCT_DESC: 30-inch corrugated metal gravity drainage pipe through the levee, 9.8 feet below the crown. Flap gate on the waterside (WS) end. Concrete headwall on the landside (LS) end. Concrete U-shaped headwall on the WS end. [Additional Reference(s): DWR Levee Log, 2002. USACE San Joaquin O&M Manual 601.1, 1967, (HLM 28.69)]. FS Date: 3/27/2014

Concrete headwall on WS toe.

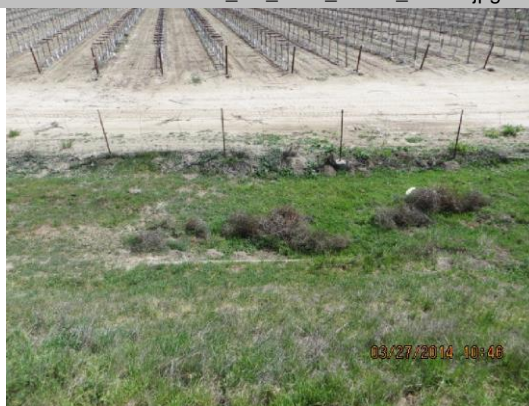
Photo 2 of 3 : UCIP_SP_2019_32832_59419.jpg

LM Start	28.79	Rating **	A/W	Issue No.	1388 (cont)	
LM End	28.79	Issue Type +	Ma	Location *		
Category	Supplemental			GPS Latitude/Longitude		
				Start		End
Item	DWR UCIP LMA Responsibility			37.031640 °		37.031640 °
				-120.441389 °		-120.441389 °
DWR ID	19751					
Comment Code						
Inspector Comment						
FS_ID:32832 DS_ID:19751 EP_NO: N/A Repair Type: No Action Needed Crossing Status: Found UCIP Comments: FIELD_STRUCT_DESC: 30-inch corrugated metal gravity drainage pipe through the levee, 9.8 feet below the crown. Flap gate on the waterside (WS) end. Concrete headwall on the landside (LS) end. Concrete U-shaped headwall on the WS end. [Additional Reference(s): DWR Levee Log, 2002. USACE San Joaquin O&M Manual 601.1, 1967, (HLM 28.69)]. FS Date: 3/27/2014

Concrete headwall on LS toe.

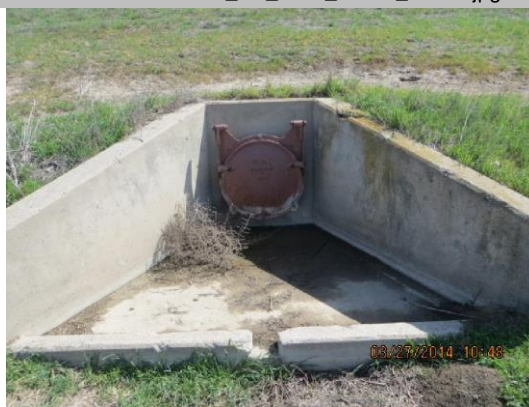
Photo 3 of 3 : UCIP_SP_2019_32832_59418.jpg

Flapgate on Concrete headwall at WS toe.

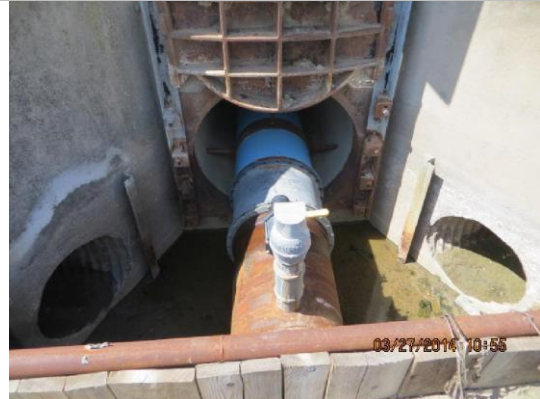
Photo 3 of 3 : UCIP_SP_2019_50055_59408.jpg

Item	DWR UCIP Field Study			37.028295 °	37.028295 °	
				-120.439275 °	-120.439275 °	
DWR ID	19752					
Comment Code						
Inspector Comment						
FS_ID:50055 DS_ID:19752 EP_NO: N/A Repair Type: Non-Urgent Crossing Status: Found UCIP Comments: 7/20/2016 same as previous inspection. Crossing has been downgraded from Urgent to Non-Urgent slide gate is on LS. Pipe is buried through WS. Need to coordinate with owner to determine permit used to authorized sleeved pipe. (DWR UCIP - O. Magana)3/27/2014 Slide gate will not close due to 24-inch PVC pipe sleeved through pipe. Also slide gate rails rusted beyond use. (DWR UCIP - W. Wylie) FIELD_STRUCT_DESC: [Rodunder Siphon Structure] 48-inch reinforced concrete irrigation siphon pipe through the levee, 12.1 feet below the crown. Concrete U-shaped headwall on inlet structure on the landside (LS) end. Slide gate mounted on concrete headwall on the LS. 36-inch corrugated metal pipe (CMP) riser with a slide gate on the LS, 8 feet upstream from the siphon. 24-inch pipe from this unit enters the siphon behind the inlet structure. [Additional Reference(s): DWR Levee Log, 2002. USACE San Joaquin O&M Manual 601.1, 1967, (HLM 28.95)]. FS Date: 7/20/2016

24-inch PVC pipe sleeved through 48-inch concrete pipe. Rails on Slide gate rusted beyond use.

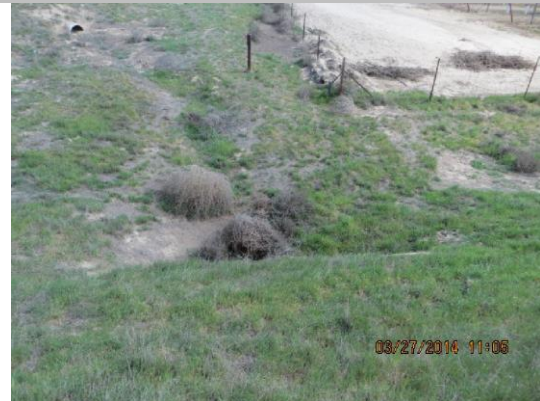
Photo 3 of 3 : UCIP_SP_2019_39884_59415.jpg

Item	DWR UCIP LMA Responsibility			37.021497 °	37.021497 °	
				-120.434602 °	-120.434602 °	
DWR ID	19753					
Comment Code						
Inspector Comment						
FS_ID:39884 DS_ID:19753 EP_NO: N/A Repair Type: Non-Urgent Crossing Status: Found UCIP Comments: 03/27/2014 Dense vegetation limits the inspector's visibility to identify signs of pipe failure (leaks) along the landward slope. Recommend removing vegetation along pipe alignment to conduct proper inspection of structure. Sediment buildup in pipe visible from landward side--recommend contacting owner to clear pipe. (DWR UCIP - W. Wylie) FIELD_STRUCT_DESC: 36-inch corrugated metal gravity drainage pipe through the levee, 10.2 feet below the crown. Flap gate on the waterside (WS) end. Concrete headwall on the landside (LS) end. Concrete U-shaped headwall on the WS end. [Additional Reference(s): DWR Levee Log, 2002. USACE San Joaquin O&M Manual 601.1, 1967, (HLM 29.49)]. FS Date: 3/27/2014

Concrete headwall on LS toe.

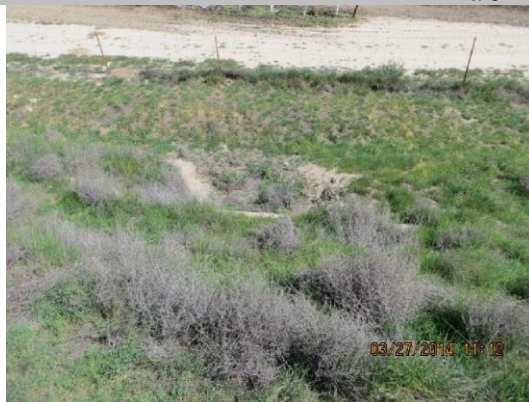
Photo 3 of 3 : UCIP_SP_2019_39631_59425.jpg

Concrete headwall on LS toe.

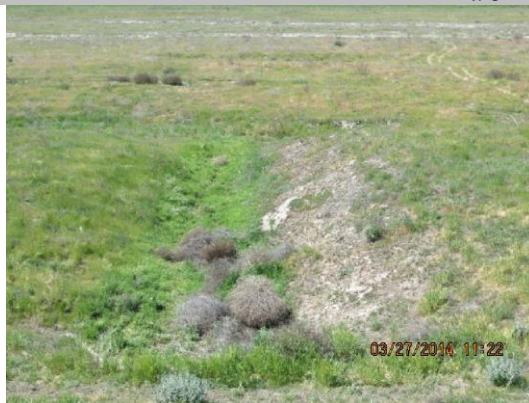
Photo 1 of 3 : UCIP_SP_2019_39632_59430.jpg

Comment Code					
Inspector Comment					
FS_ID:39632					
DS_ID:19696					
EP_NO: N/A					
Repair Type: Non-Urgent					
Crossing Status: Found					
UCIP Comments: 03/27/2014 Dense vegetation limits the inspector's visibility to identify signs of pipe failure (leaks) along the landward slope. Recommend removing vegetation along pipe alignment to conduct proper inspection of structure. (DWR UCIP - W. Wylie)					
FIELD_STRUCT_DESC: 30-inch by 30-inch reinforced concrete box gravity drainage culvert through the levee, 13.1 feet below the crown. Flap gate on the waterside (WS) end. Concrete headwall on the landside (LS) end. Concrete U-shaped headwall on the WS end. [Additional Reference(s): DWR Levee Log, 2002. USACE San Joaquin O&M Manual 601.1, 1967, (HLM 30.04)].					
FS Date: 3/27/2014

Concrete headwall on WS toe.

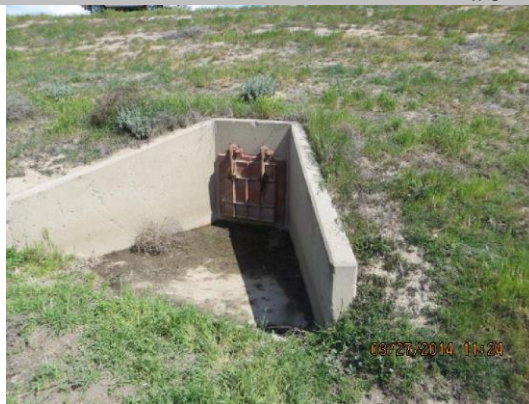
Photo 2 of 3 : UCIP_SP_2019_39632_59431.jpg

Flapgate on Concrete headwall at WS toe.

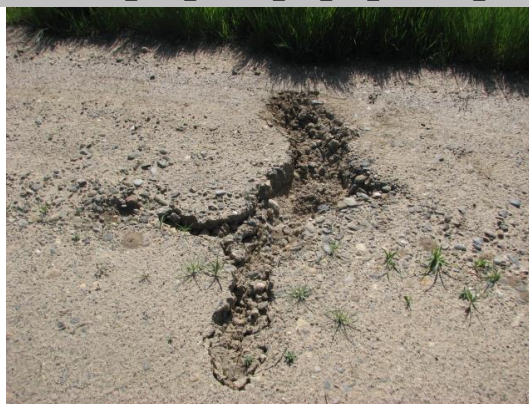
Photo 1 of 2 : SP_2019_NA0010_123_133_20190307_00032.jpg

LM Start	30.31	Rating **	M	Issue No.	133
LM End	30.31	Issue Type +	Ma	Location *	CR
Category	Earthen Levee			GPS Latitude/Longitude	
				Start	End
Item	Crown Surface / Depressions / Rutting			37.012273 °	37.012273 °
				-120.428244 °	-120.428244 °
DWR ID	DWR_NA0010_05_s_2018_133				
Comment Code					
C2 : Repair depressions or ruts in the crown or slope.					
Inspector Comment					
There is a minor depression on levee crown. Possible sink hole.

Looking east at depression on levee crown. (Spring 2018)

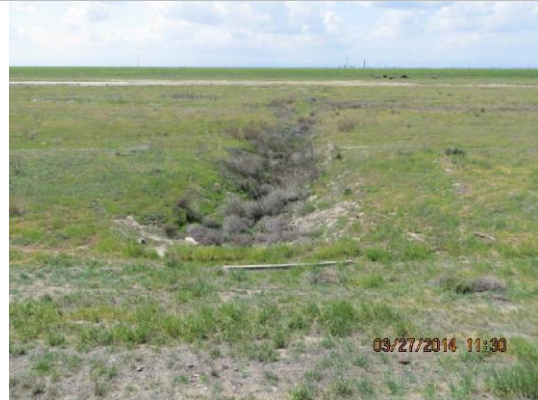
Photo 1 of 3 : UCIP_SP_2019_39633_59435.jpg

Comment Code					
Inspector Comment					
FS_ID:39633					
DS_ID:19697					
EP_NO: N/A					
Repair Type: Non-Urgent					
Crossing Status: Found					
UCIP Comments: 03/27/2014 Some debris buildup at LS toe. Dense vegetation limits the inspector's visibility to identify signs of pipe failure (leaks) along the landward slope. Recommend removing vegetation along pipe alignment to conduct proper inspection of structure. (DWR UCIP - W. Wylie)					
FIELD_STRUCT_DESC: 30-inch by 30-inch reinforced concrete box gravity drainage culvert through the levee, 13.3 feet below the crown. Flap gate on the waterside (WS) end. Concrete headwall on the landside (LS) end. Concrete U-shaped headwall on the WS end.					
[Additional Reference(s): DWR Levee Log, 2002. USACE San Joaquin O&M Manual 601.1, 1967, (HLM 30.96)].					
FS Date: 3/27/2014

Concrete headwall on WS toe.

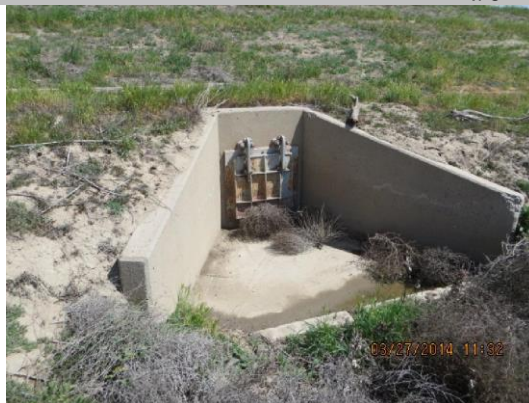
Photo 2 of 3 : UCIP_SP_2019_39633_59436.jpg

Item	DWR UCIP LMA Responsibility			37.004212 °	37.004212 °	
				-120.419178 °	-120.419178 °	
DWR ID	19697					
Comment Code						
Inspector Comment						
FS_ID:39633 DS_ID:19697 EP_NO: N/A Repair Type: Non-Urgent Crossing Status: Found UCIP Comments: 03/27/2014 Some debris buildup at LS toe. Dense vegetation limits the inspector's visibility to identify signs of pipe failure (leaks) along the landward slope. Recommend removing vegetation along pipe alignment to conduct proper inspection of structure. (DWR UCIP - W. Wylie) FIELD_STRUCT_DESC: 30-inch by 30-inch reinforced concrete box gravity drainage culvert through the levee, 13.3 feet below the crown. Flap gate on the waterside (WS) end. Concrete headwall on the landside (LS) end. Concrete U-shaped headwall on the WS end. [Additional Reference(s): DWR Levee Log, 2002. USACE San Joaquin O&M Manual 601.1, 1967, (HLM 30.96)]. FS Date: 3/27/2014

Flapgate on Concrete headwall at WS toe.

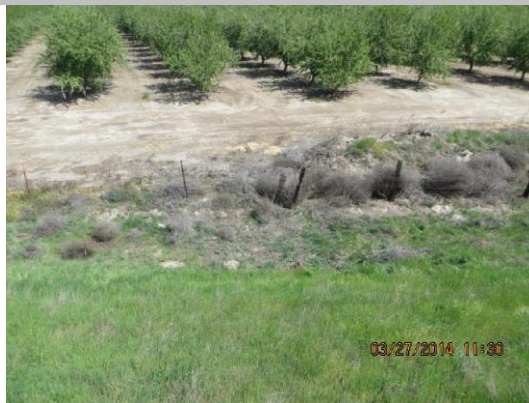
Photo 3 of 3 : UCIP_SP_2019_39633_59434.jpg

Concrete headwall on LS toe.

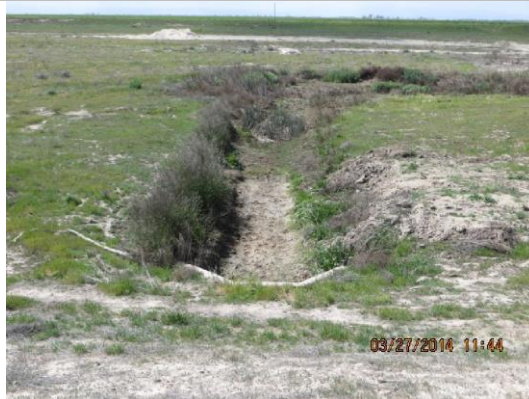
Photo 1 of 3 : UCIP_SP_2019_39643_59439.jpg

Comment Code					
Inspector Comment					
FS_ID:39643 DS_ID:19698 EP_NO: N/A Repair Type: Non-Urgent Crossing Status: Found UCIP Comments: 03/27/2014 Excess vegetation buildup at inlet on LS toe. Dense vegetation limits the inspector's visibility to identify signs of pipe failure (leaks) along the landward slope. Recommend removing vegetation along pipe alignment to conduct proper inspection of structure. (DWR UCIP - W. Wylie) FIELD_STRUCT_DESC: 30-inch by 30-inch reinforced concrete box gravity drainage culvert through the levee, 13.4 feet below the crown. Flap gate on the waterside (WS) end. Concrete headwall on the landside (LS) end. Concrete U-shaped headwall on the WS end. [Additional Reference(s): DWR Levee Log, 2002. USACE San Joaquin O&M Manual 601.1, 1967, (HLM 31.19)]. FS Date: 3/27/2014

Concrete headwall on WS toe.

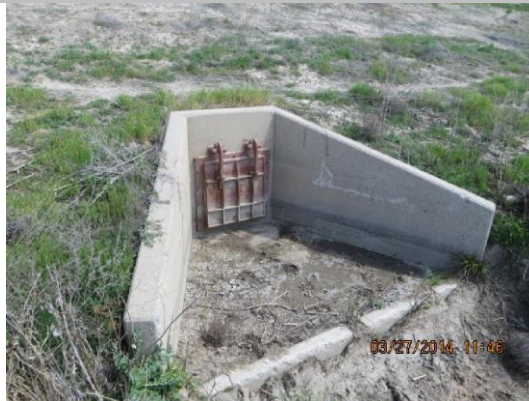
Photo 2 of 3 : UCIP_SP_2019_39643_59440.jpg

Flapgate at concrete headwall on WS toe.

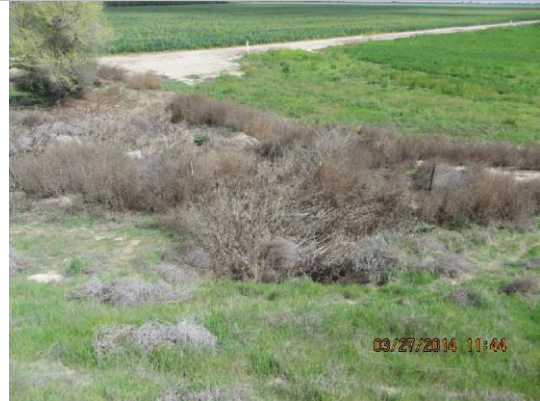
Photo 3 of 3 : UCIP_SP_2019_39643_59438.jpg

Item	DWR UCIP LMA Responsibility			37.001754 °	37.001754 °	
				-120.416254 °	-120.416254 °	
DWR ID	19698					
Comment Code						
Inspector Comment						
FS_ID:39643 DS_ID:19698 EP_NO: N/A Repair Type: Non-Urgent Crossing Status: Found UCIP Comments: 03/27/2014 Excess vegetation buildup at inlet on LS toe. Dense vegetation limits the inspector's visibility to identify signs of pipe failure (leaks) along the landward slope. Recommend removing vegetation along pipe alignment to conduct proper inspection of structure. (DWR UCIP - W. Wylie) FIELD_STRUCT_DESC: 30-inch by 30-inch reinforced concrete box gravity drainage culvert through the levee, 13.4 feet below the crown. Flap gate on the waterside (WS) end. Concrete headwall on the landside (LS) end. Concrete U-shaped headwall on the WS end. [Additional Reference(s): DWR Levee Log, 2002. USACE San Joaquin O&M Manual 601.1, 1967, (HLM 31.19)]. FS Date: 3/27/2014

Concrete headwall on LS toe.

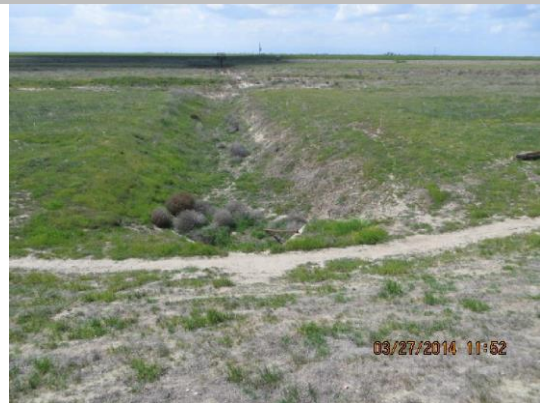
Photo 1 of 3 : UCIP_SP_2019_39644_59444.jpg

LM Start	31.74	Rating **	A/W	Issue No.	1395
LM End	31.74	Issue Type +	Ma	Location *	
Category	Supplemental			GPS Latitude/Longitude	
				Start	End
Item	DWR UCIP LMA Responsibility			36.997001 °	36.997001 °
				-120.410991 °	-120.410991 °
DWR ID	19699				
Comment Code					
Inspector Comment					
FS_ID:39644					
DS_ID:19699					
EP_NO: N/A					
Repair Type: No Action Needed					
Crossing Status: Found					
UCIP Comments:					
FIELD_STRUCT_DESC: 48-inch by 36-inch reinforced concrete box gravity drainage culvert through the levee, 14.5 feet below the crown. Flap gate on the waterside (WS) end. Concrete U-shaped headwall on each end. [Additional Reference(s): DWR Levee Log, 2002. USACE San Joaquin O&M Manual 601.1, 1967, (HLM 31.64)].					
FS Date: 3/27/2014

Concrete headwall on WS toe.

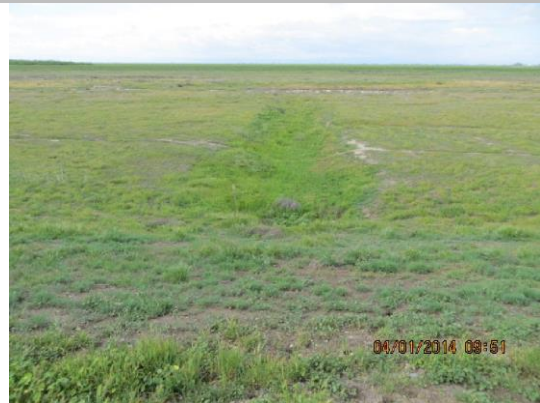
Photo 1 of 3 : UCIP_SP_2019_39645_59686.jpg

Comment Code					
Inspector Comment					
FS_ID:39645 DS_ID:19700 EP_NO: N/A Repair Type: Non-Urgent Crossing Status: Found UCIP Comments: 04/01/2014 Dense vegetation limits the inspector's visibility to identify signs of pipe failure (leaks) along the landward slope. Recommend removing vegetation along pipe alignment to conduct proper inspection of structure. (DWR UCIP - W. Wylie) FIELD_STRUCT_DESC: 30-inch by 30-inch reinforced concrete box gravity drainage culvert through the levee, 13 feet below the crown. Flap gate on the waterside (WS) end. Concrete headwall on the landside (LS) end with flashboard attachment. Concrete U-shaped headwall on the WS end. [Additional Reference(s): DWR Levee Log, 2002. USACE San Joaquin O&M Manual 601.1, 1967, (HLM 31.71)]. FS Date: 4/1/2014

Concrete headwall at channel on WS toe.

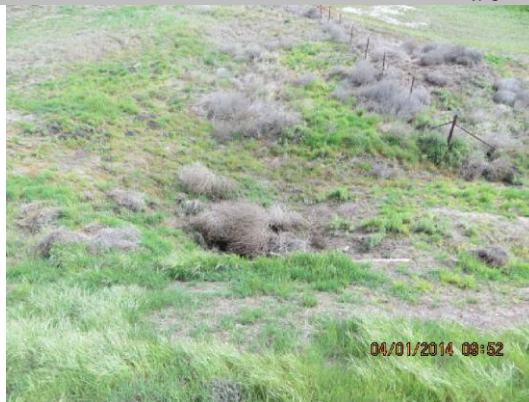
Photo 3 of 3 : UCIP_SP_2019_39645_59685.jpg

Concrete headwall on LS toe.

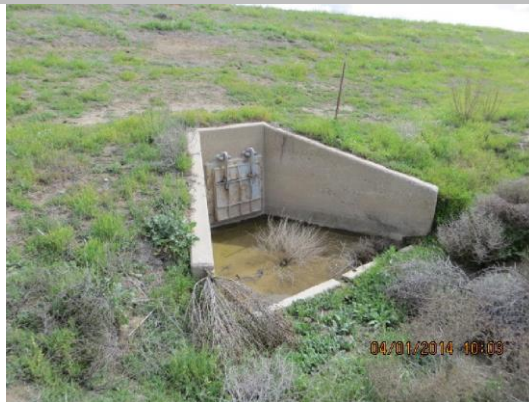
Photo 2 of 3 : UCIP_SP_2019_39646_59688.jpg

Flapgate on Concrete headwall at WS toe.

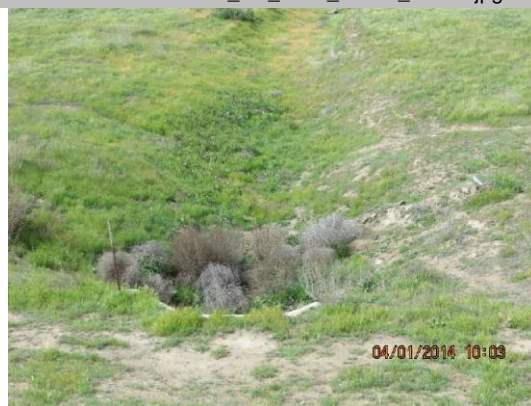
Photo 3 of 3 : UCIP_SP_2019_39646_59689.jpg

LM Start	32.32	Rating **	M	Issue No.	1397 (cont)	
LM End	32.32	Issue Type +	Ma	Location *		
Category	Supplemental			GPS Latitude/Longitude		
				Start		End
Item	DWR UCIP LMA Responsibility			36.989435 °		36.989435 °
				-120.402626 °		-120.402626 °
DWR ID	19701					
Comment Code						
Inspector Comment						
FS_ID:39646 DS_ID:19701 EP_NO: N/A Repair Type: Non-Urgent Crossing Status: Found UCIP Comments: 04/01/2014 Some silt buildup inside culvert. (DWR UCIP - W. Wylie) FIELD_STRUCT_DESC: 30-inch by 30-inch reinforced concrete box gravity drainage culvert through the levee, 14.2 feet below the crown. Flap gate on the waterside (WS) end. Concrete headwall on the landside (LS) end with flashboard attachment. Concrete U-shaped headwall on the WS end. [Additional Reference(s): DWR Levee Log, 2002. USACE San Joaquin O&M Manual 601.1, 1967, (HLM 32.22)]. FS Date: 4/1/2014

Concrete headwall at outlet on WS toe.

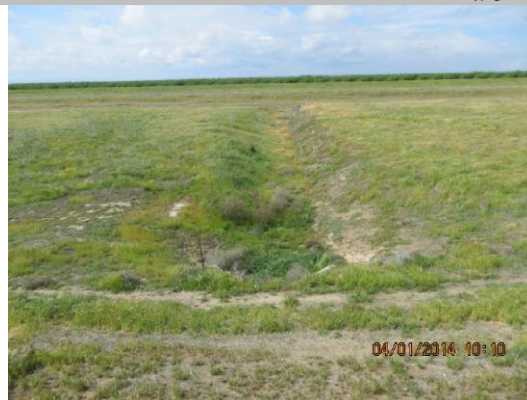
Photo 1 of 3 : UCIP_SP_2019_39647_59697.jpg

Comment Code						
Inspector Comment						
FS_ID:39647 DS_ID:19702 EP_NO: N/A Repair Type: Non-Urgent Crossing Status: Found UCIP Comments: 04/01/2014 Dense vegetation limits the inspector's visibility to identify signs of pipe failure (leaks) along the landward slope. Recommend removing vegetation along pipe alignment to conduct proper inspection of structure. Debris buildup blocking landward headwall--recommend contacting owner to clear debris. (DWR UCIP - W. Wylie) FIELD_STRUCT_DESC: 30-inch by 30-inch reinforced concrete box gravity drainage culvert through the levee, 12.2 feet below the crown. Flap gate on the waterside (WS) end. Concrete headwall on the landside (LS) end. Concrete U-shaped headwall on the WS end. [Additional Reference(s): DWR Levee Log, 2002. USACE San Joaquin O&M Manual 601.1, 1967, (HLM 33.01)]. FS Date: 4/1/2014

Concrete headwall at WS toe.

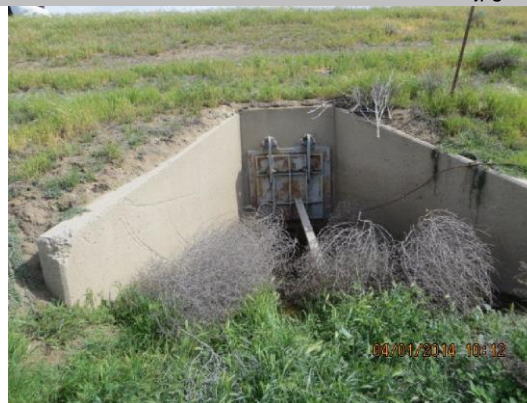
Photo 2 of 3 : UCIP_SP_2019_39647_59699.jpg

Flapgate on Concrete headwall at WS toe.

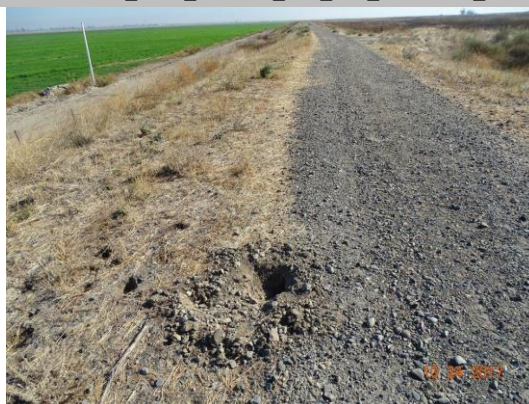
Photo 1 of 1 : SP_2019_NA0010_123_130_20190307_00029.jpg

LM Start	33.82	Rating **	M	Issue No.	130
LM End	33.82	Issue Type +	Ma	Location *	LS
Category	Earthen Levee			GPS Latitude/Longitude	
				Start	End
Item	Animal Control			36.976849 °	36.976849 °
				-120.382393 °	-120.382393 °
DWR ID	DWR_NA0010_05_f_2017_130				
Comment Code					
A3 : No rodents visible, but rodent burrows visible; need to backfill and compact or grout burrows.					
Inspector Comment

Looking east at the landside shoulder.

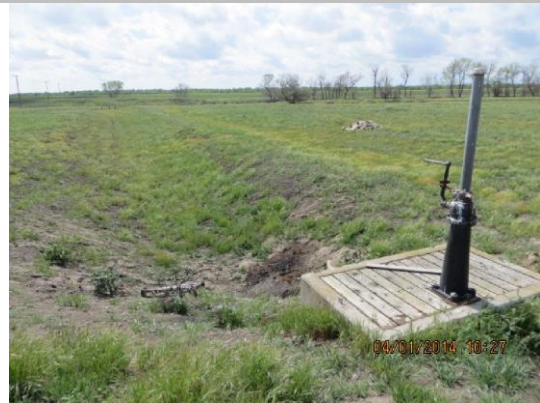
Photo 1 of 3 : UCIP_SP_2019_39649_59706.jpg

Comment Code						
Inspector Comment						
FS_ID:39649 DS_ID:19755 EP_NO: N/A Repair Type: Non-Urgent Crossing Status: Found UCIP Comments: 04/01/2014 Dense vegetation limits the inspector's visibility to identify signs of pipe failure (leaks) along the landward slope. Recommend removing vegetation along pipe alignment to conduct proper inspection of structure. Debris buildup visible on waterward headwall--recommend contacting owner to clear pipe. (DWR UCIP - W. Wylie) FIELD_STRUCT_DESC: [Chowchilla Canal Irrigation Structure] 36-inch by 36-inch reinforced concrete box gravity irrigation culvert through the levee, 9.7 feet below the crown. Slide gate in a 56-inch by 91-inch concrete riser on the waterside (WS) slope. Concrete U-shaped headwall on each end. Landside channel cobble revetted for 8 feet. [Additional Reference(s): DWR Levee Log, 2002. USACE San Joaquin O&M Manual 601.1, 1967, (HLM 34.51)]. FS Date: 4/1/2014

Slide gate in concrete riser on WS shoulder.

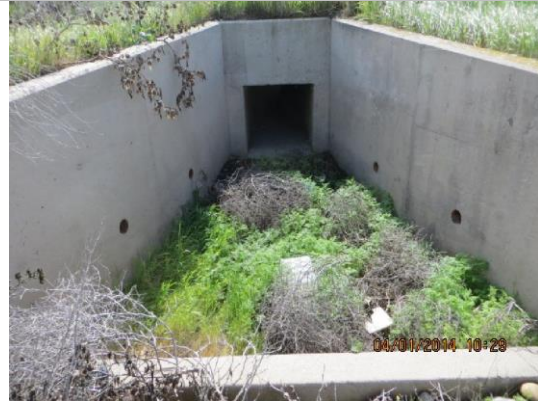
Photo 2 of 3 : UCIP_SP_2019_39649_59704.jpg

Concrete headwall at LS toe.

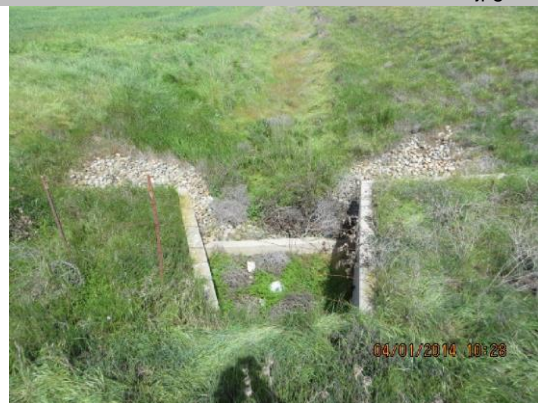
Photo 3 of 3 : UCIP_SP_2019_39649_59705.jpg

Concrete headwall at LS toe.

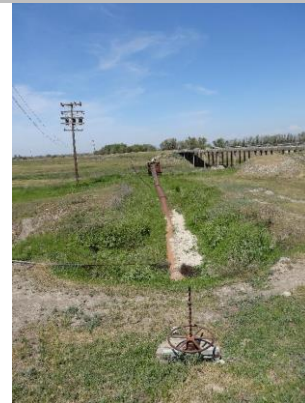
Photo 1 of 3 : UCIP_SP_2019_39463_66341.jpg

Comment Code						
Inspector Comment						
FS_ID:39463						
DS_ID:19815						
EP_NO: N/A						
Repair Type: Non-Urgent						
Crossing Status: Found						
UCIP Comments: 04/18/2014 Need to contact owner. Sediment buildup on landward side. Recommend removing sediment buildup on landward toe. (DWR UCIP - O. Magana)						
FIELD_STRUCT_DESC: 24-inch corrugated metal irrigation discharge pipe through the levee, 7.2 feet below the crown. Pump on concrete structure in the channel. Slide gate in a 36-inch corrugated metal pipe (CMP) riser on the waterside (WS) slope. Concrete headwall on each end. [Additional Reference(s): DWR Levee Log, 2002. USACE San Joaquin O&M Manual 601.1, 1967, (HLM 0.74)].						
FS Date: 4/18/2014

View of waterward side.

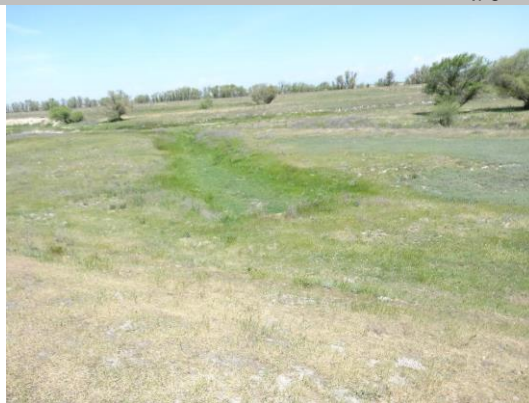
Photo 1 of 3 : UCIP_SP_2019_36565_66346.jpg

LM Start	0.78	Rating **	M	Issue No.	1213
LM End	0.78	Issue Type +	Ma	Location *	
Category	Supplemental			GPS Latitude/Longitude	
				Start	End
Item	DWR UCIP LMA Responsibility			37.270460 °	37.270460 °
				-120.814290 °	-120.814290 °
DWR ID	19816				
Comment Code					
Inspector Comment					
FS_ID:36565 DS_ID:19816 EP_NO: N/A Repair Type: Non-Urgent Crossing Status: Found UCIP Comments: 04/18/2014 Landward side blocked--need to contact owner to determine status of crossing. (DWR UCIP - O. Magana) FIELD_STRUCT_DESC: 24-inch corrugated metal gravity drainage pipe through the levee, 16.2 feet below the crown. Flap gate on the waterside (WS) end. Concrete U-shaped headwall on each end. [Additional Reference(s): DWR Levee Log, 2002. USACE San Joaquin O&M Manual 601.1, 1967, (HLM 0.86)]. FS Date: 4/18/2014

Overview of waterward side.

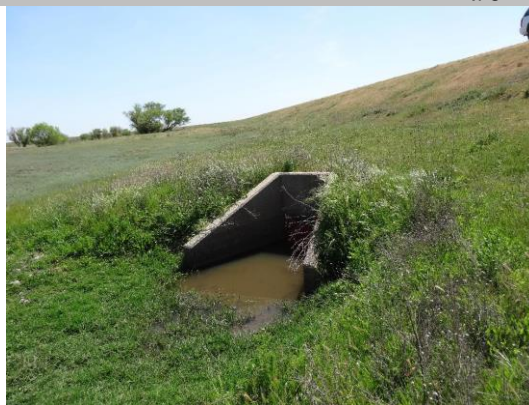
Photo 2 of 3 : UCIP_SP_2019_36565_66345.jpg

Concrete structure located on waterward toe.

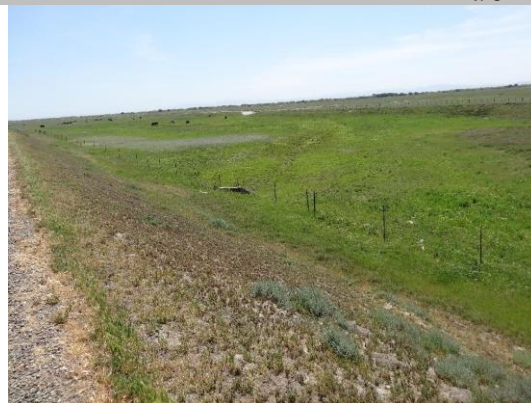
Photo 3 of 3 : UCIP_SP_2019_36565_66344.jpg

LM Start	0.78	Rating **	M	Issue No.	1213 (cont)	
LM End	0.78	Issue Type +	Ma	Location *		
Category	Supplemental			GPS Latitude/Longitude		
				Start	End	
Item	DWR UCIP LMA Responsibility			37.270460 °	37.270460 °	
				-120.814290 °	-120.814290 °	
DWR ID	19816					
Comment Code						
Inspector Comment						
FS_ID:36565 DS_ID:19816 EP_NO: N/A Repair Type: Non-Urgent Crossing Status: Found UCIP Comments: 04/18/2014 Landward side blocked--need to contact owner to determine status of crossing. (DWR UCIP - O. Magana) FIELD_STRUCT_DESC: 24-inch corrugated metal gravity drainage pipe through the levee, 16.2 feet below the crown. Flap gate on the waterside (WS) end. Concrete U-shaped headwall on each end. [Additional Reference(s): DWR Levee Log, 2002. USACE San Joaquin O&M Manual 601.1, 1967, (HLM 0.86)]. FS Date: 4/18/2014

View of landward side.

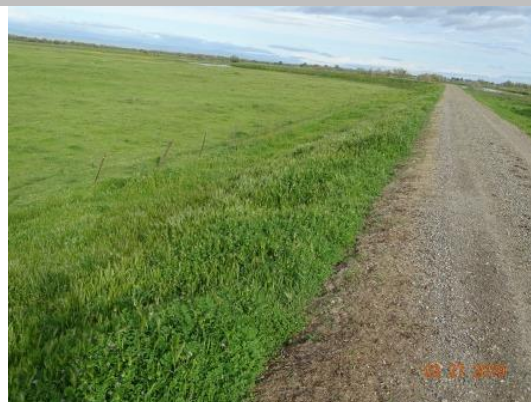
Photo 1 of 1 : SP_2019_NA0010_124_62_20190418_00190.jpg

LM Start	0.97	Rating **	M	Issue No.	62
LM End	1.90	Issue Type +	Ma	Location *	LS
Category	Earthen Levee			GPS Latitude/Longitude	
				Start	End
Item	Vegetation			37.268366 °	37.259076 °
				-120.812706 °	-120.802346 °
DWR ID	DWR_NA0010_06_s_2019_62				
Comment Code					
V1 : Control annual grass and weeds on the levee slopes and easements.					
Inspector Comment

View of landside slope looking upstream. (Spring 2019)

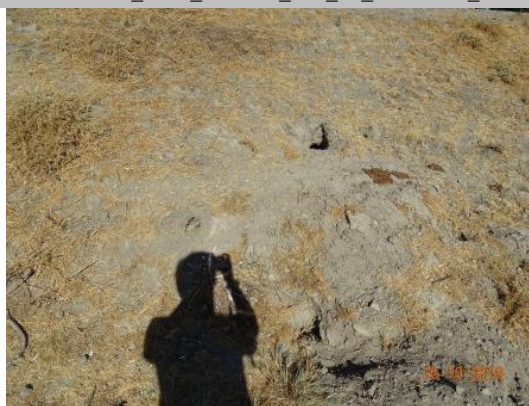
Photo 1 of 2 : SP_2019_NA0010_124_93_20190307_00040.jpg

LM Start	1.18	Rating **	U	Issue No.	93
LM End	1.18	Issue Type +	Ma	Location *	LS
Category	Earthen Levee			GPS Latitude/Longitude	
				Start	End
Item	Animal Control			37.267101 °	37.267101 °
				-120.809603 °	-120.809603 °
DWR ID	DWR_NA0010_06_f_2018_93				
Comment Code					
A3 : No rodents visible, but rodent burrows visible; need to backfill and compact or grout burrows.					
Inspector Comment					
Several rodent burrows including large burrows were observed at this location.

View of landside slope. (Fall 2018)

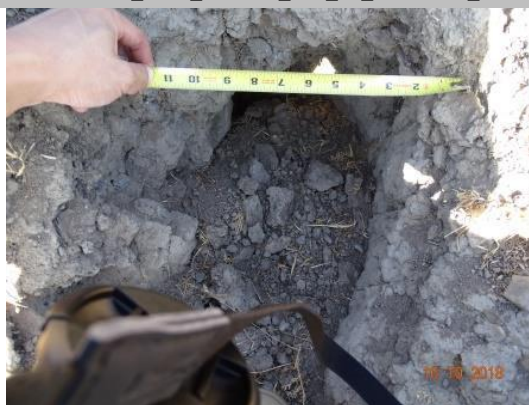
Photo 2 of 2 : SP_2019_NA0010_124_93_20190307_00041.jpg

View and measurement of large rodent hole found at this location. (Fall 2018)

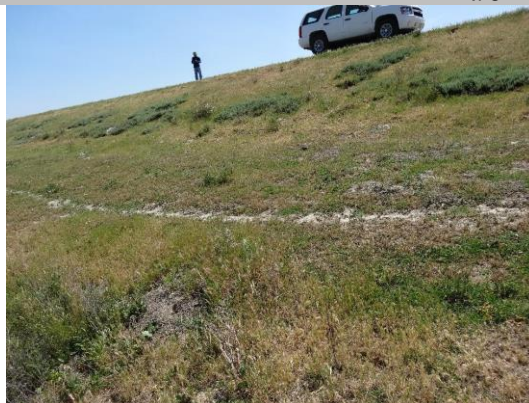
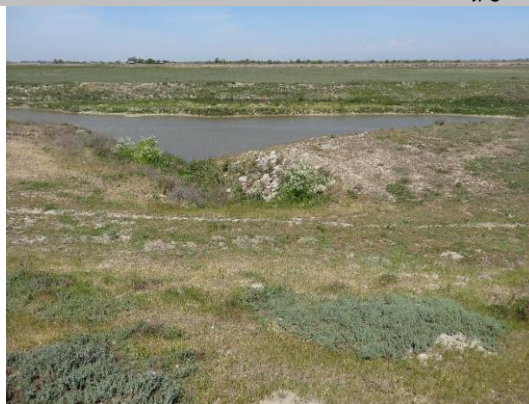
Photo 1 of 3 : UCIP_SP_2019_36566_66348.jpg

LM Start	1.87	Rating **	M	Issue No.	1214
LM End	1.87	Issue Type +	Ma	Location *	
Category	Supplemental			GPS Latitude/Longitude	
				Start	End
Item	DWR UCIP LMA Responsibility			37.259312 °	37.259312 °
				-120.802863 °	-120.802863 °
DWR ID	19817				
Comment Code					
Inspector Comment					
FS_ID:36566 DS_ID:19817 EP_NO: N/A Repair Type: Non-Urgent Crossing Status: Found UCIP Comments: 04/18/2014 No access was available to landward side due to fence. Recommend removing some of the vegetation on waterward toe. (DWR UCIP - O. Magana) FIELD_STRUCT_DESC: 24-inch corrugated metal gravity drainage pipe through the levee, 13.5 feet below the crown. Flap gate on the waterside (WS) end. Concrete headwall on each end. [Additional Reference(s): DWR Levee Log, 2002. USACE San Joaquin O&M Manual 601.1, 1967, (HLM 1.95)]. FS Date: 4/18/2014

View of waterward side.

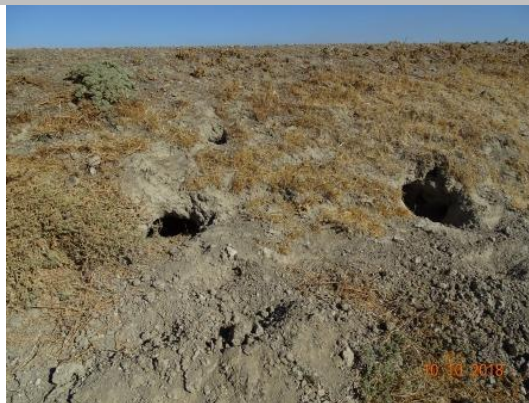
Photo 1 of 2 : SP_2019_NA0010_124_92_20190307_00038.jpg

LM Start	2.42	Rating **	U	Issue No.	92
LM End	2.42	Issue Type +	Ma	Location *	LS
Category	Earthen Levee			GPS Latitude/Longitude	
				Start	End
Item	Animal Control			37.254519 °	37.254519 °
				-120.795141 °	-120.795141 °
DWR ID	DWR_NA0010_06_f_2018_92				
Comment Code					
A3 : No rodents visible, but rodent burrows visible; need to backfill and compact or grout burrows.					
Inspector Comment

View of large rodent holes in landside slope. (Fall 2018)

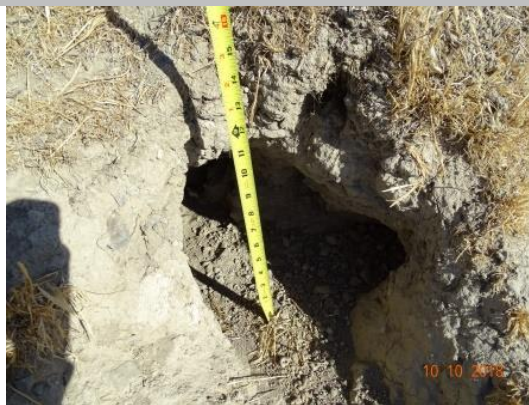
Photo 2 of 2 : SP_2019_NA0010_124_92_20190307_00039.jpg

Measurement of large burrow. (Fall 2018)

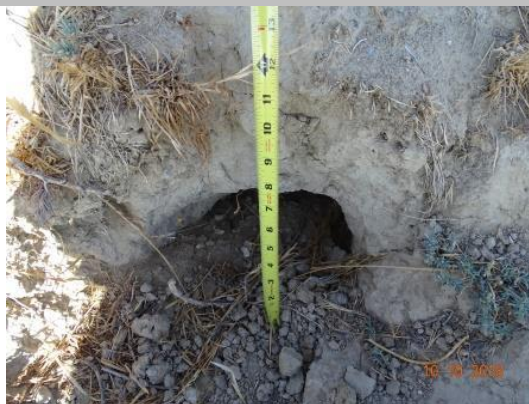
Photo 1 of 1 : SP_2019_NA0010_124_76_20190307_00024.jpg

LM Start	2.54	Rating **	M	Issue No.	76
LM End	2.54	Issue Type +	Ma	Location *	LS
Category	Earthen Levee			GPS Latitude/Longitude	
				Start	End
Item	Animal Control			37.252874 °	37.252874 °
				-120.794192 °	-120.794192 °
DWR ID	DWR_NA0010_06_f_2016_76				
Comment Code					
A3 : No rodents visible, but rodent burrows visible; need to backfill and compact or grout burrows.					
Inspector Comment					
There are several rodent burrows in the landside slope at this location.

Representative view of rodent burrow found at this section. (Fall 2018)

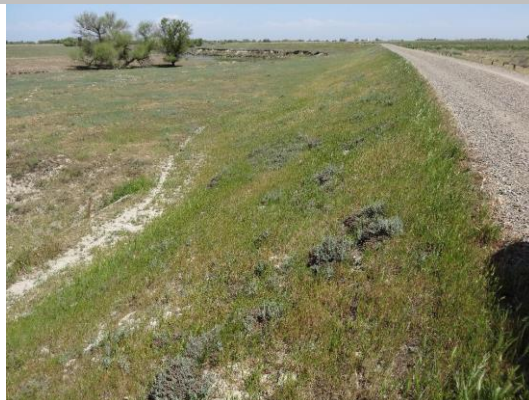
Photo 1 of 3 : UCIP_SP_2019_36568_66362.jpg

Comment Code						
Inspector Comment						
FS_ID:36568 DS_ID:19819 EP_NO: N/A Repair Type: Non-Urgent Crossing Status: Found UCIP Comments: 04/18/2014 Dense vegetation limits the inspector's visibility to identify signs of pipe condition on landward toe--headwall blocked by dense vegetation. Recommend removing vegetation from landward toe. (DWR UCIP - O. Magana) FIELD_STRUCT_DESC: 24-inch corrugated metal gravity drainage pipe through the levee, 9.2 feet below the crown. Flap gate on the waterside (WS) end. Concrete headwall on each end. [Additional Reference(s): DWR Levee Log, 2002. USACE San Joaquin O&M Manual 601.1, 1967, (HLM 2.65)]. FS Date: 4/18/2014

Overview of levee crown at crossing.

View of waterward side.

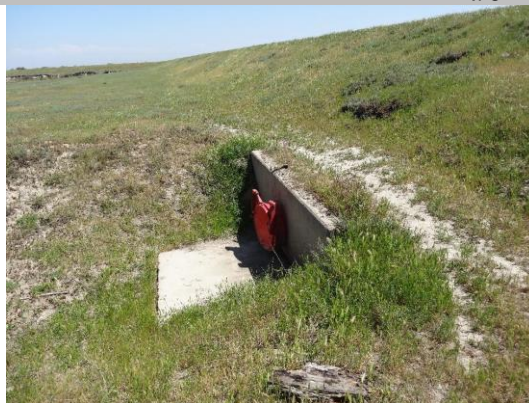
Photo 3 of 3 : UCIP_SP_2019_36568_66359.jpg

Comment Code						
Inspector Comment						
FS_ID:36568 DS_ID:19819 EP_NO: N/A Repair Type: Non-Urgent Crossing Status: Found UCIP Comments: 04/18/2014 Dense vegetation limits the inspector's visibility to identify signs of pipe condition on landward toe--headwall blocked by dense vegetation. Recommend removing vegetation from landward toe. (DWR UCIP - O. Magana) FIELD_STRUCT_DESC: 24-inch corrugated metal gravity drainage pipe through the levee, 9.2 feet below the crown. Flap gate on the waterside (WS) end. Concrete headwall on each end. [Additional Reference(s): DWR Levee Log, 2002. USACE San Joaquin O&M Manual 601.1, 1967, (HLM 2.65)]. FS Date: 4/18/2014

View of concrete headwall, flap gate, and concrete apron located on waterward side.

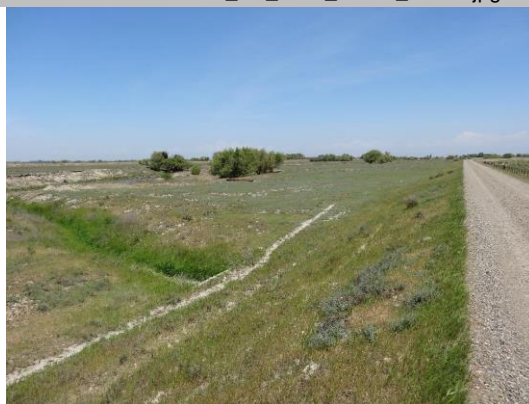
Photo 1 of 3 : UCIP_SP_2019_36569_66369.jpg

Comment Code					
Inspector Comment					
FS_ID:36569 DS_ID:19820 EP_NO: N/A Repair Type: Non-Urgent Crossing Status: Found UCIP Comments: 04/18/2014 Dense vegetation limits the inspector's visibility to identify signs of pipe condition on landward toe--headwall blocked by dense vegetation. Recommend removing vegetation from landward toe. (DWR UCIP - O. Magana) FIELD_STRUCT_DESC: 24-inch corrugated metal gravity drainage pipe through the levee, 10.5 feet below the crown. Flap gate on the waterside (WS) end. Concrete headwall on each end. [Additional Reference(s): DWR Levee Log, 2002. USACE San Joaquin O&M Manual 601.1, 1967, (HLM 2.85)]. FS Date: 4/18/2014

View of waterward side.
