**Flood Control Project Maintenance
Levee Inspections**
LMA District Cover Sheet
Spring 2019 Levee Inspection Results

Lower San Joaquin Levee District

Spring 2019 Levee Inspection Results

Waterway			Bank	Unit Miles
Unit No. 01 San Joaquin River			Right	22.52
	Spring (March - May)	Summer (June - August)	(September - November) Fall	Winter (December - February)
Unit Maintenance Rating (Fall Only)				
Date of Inspection	3/26/2019 - 3/26/2019			
DWR Inspector	Corey Fujitani			
Accompanied By

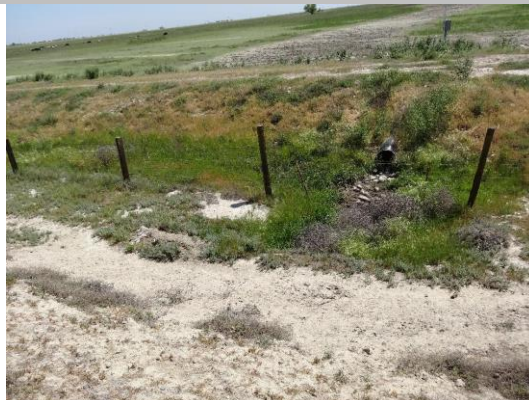
Photo 2 of 3 : UCIP_SP_2019_36569_66368.jpg

Comment Code						
Inspector Comment						
FS_ID:36569 DS_ID:19820 EP_NO: N/A Repair Type: Non-Urgent Crossing Status: Found UCIP Comments: 04/18/2014 Dense vegetation limits the inspector's visibility to identify signs of pipe condition on landward toe--headwall blocked by dense vegetation. Recommend removing vegetation from landward toe. (DWR UCIP - O. Magana) FIELD_STRUCT_DESC: 24-inch corrugated metal gravity drainage pipe through the levee, 10.5 feet below the crown. Flap gate on the waterside (WS) end. Concrete headwall on each end. [Additional Reference(s): DWR Levee Log, 2002. USACE San Joaquin O&M Manual 601.1, 1967, (HLM 2.85)]. FS Date: 4/18/2014

Overview of levee crown at crossing.

View of landward side.

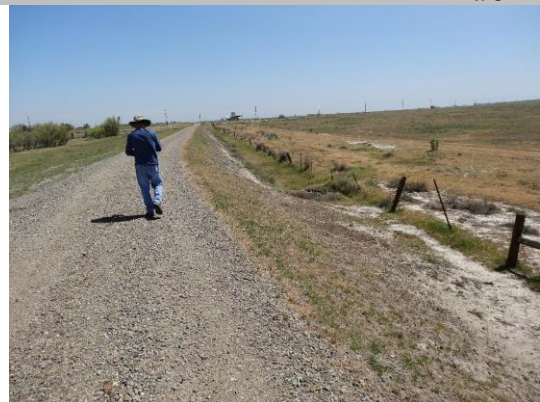
Photo 1 of 3 : UCIP_SP_2019_36584_66384.jpg

Comment Code						
Inspector Comment						
FS_ID:36584 DS_ID:19822 EP_NO: N/A Repair Type: Non-Urgent Crossing Status: Found UCIP Comments: 04/18/2014 Dense vegetation limits the inspector's visibility to identify signs of pipe condition on waterward slope and landward toe (headwall blocked by dense vegetation). Recommend removing vegetation from landward toe. (DWR UCIP - O. Magana) FIELD_STRUCT_DESC: 24-inch corrugated metal gravity drainage pipe through the levee, 10.4 feet below the crown. Flap gate on the waterside (WS) end. Concrete headwall on each end. [Additional Reference(s): DWR Levee Log, 2002. USACE San Joaquin O&M Manual 601.1, 1967, (HLM 3.29)]. FS Date: 4/18/2014

Overview of levee crown and landward side.

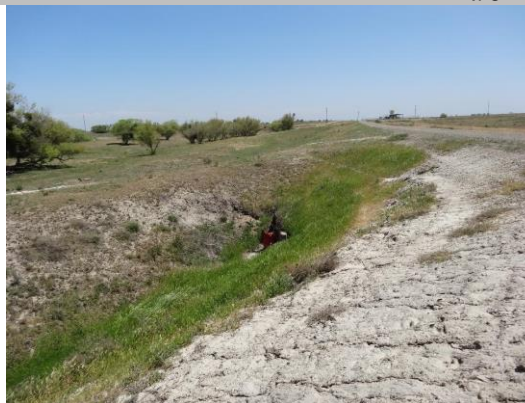
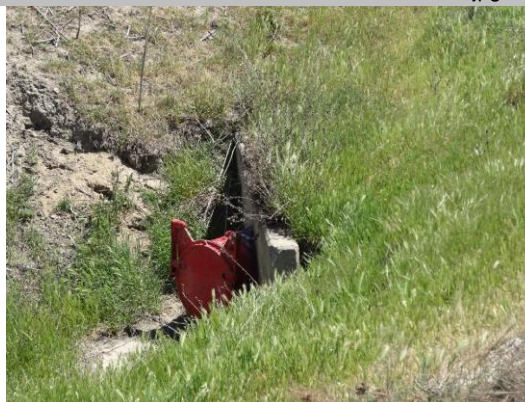
Photo 2 of 3 : UCIP_SP_2019_36584_66386.jpg

Comment Code						
Inspector Comment						
FS_ID:36584 DS_ID:19822 EP_NO: N/A Repair Type: Non-Urgent Crossing Status: Found UCIP Comments: 04/18/2014 Dense vegetation limits the inspector's visibility to identify signs of pipe condition on waterward slope and landward toe (headwall blocked by dense vegetation). Recommend removing vegetation from landward toe. (DWR UCIP - O. Magana) FIELD_STRUCT_DESC: 24-inch corrugated metal gravity drainage pipe through the levee, 10.4 feet below the crown. Flap gate on the waterside (WS) end. Concrete headwall on each end. [Additional Reference(s): DWR Levee Log, 2002. USACE San Joaquin O&M Manual 601.1, 1967, (HLM 3.29)]. FS Date: 4/18/2014

View of waterward side.

Crossing goes through the levee at an angle. Flap gate visible on waterward side.

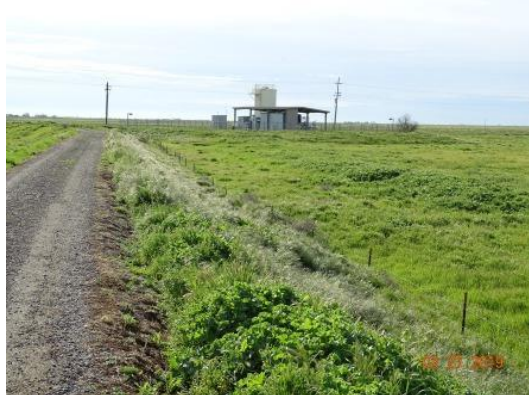
Photo 1 of 1 : SP_2019_NA0010_124_71_20190418_00192.jpg

LM Start	3.33	Rating **	M	Issue No.	71
LM End	3.85	Issue Type +	Ma	Location *	LS
Category	Earthen Levee			GPS Latitude/Longitude	
				Start	End
Item	Vegetation			37.252512 °	37.251096 °
				-120.780643 °	-120.771711 °
DWR ID	DWR_NA0010_06_s_2019_71				
Comment Code					
V1 : Control annual grass and weeds on the levee slopes and easements.					
Inspector Comment

View of landside slope looking upstream. (Spring 2019)

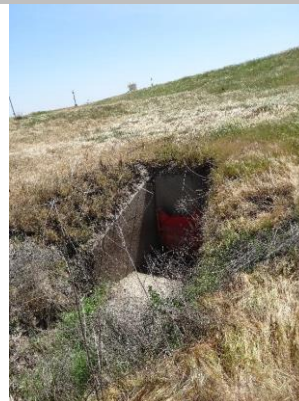
Photo 1 of 3 : UCIP_SP_2019_36585_66389.jpg

Comment Code					
Inspector Comment					
FS_ID:36585 DS_ID:19823 EP_NO: N/A Repair Type: Non-Urgent Crossing Status: Found UCIP Comments: 04/18/2014 Alignment of crossing unknown--altered crossing. No headwall found on landward side only siphon breaker found a short distance from landward toe. Tall grass observed on waterward slope and some burrow activity also noticed. Need to contact owner to determine alignment of crossing and status of crossing. (DWR UCIP - O. Magana) FIELD_STRUCT_DESC: 36-inch corrugated metal gravity drainage pipe through the levee, 15.7 feet below the crown. Flap gate on the waterside (WS) end. Concrete U-shaped headwall on each end. Bench mark (BM) stamped 9770-152 on top of the WS headwall. [Additional Reference(s): DWR Levee Log, 2002. USACE San Joaquin O&M Manual 601.1, 1967, (HLM 3.43)]. FS Date: 4/18/2014

Overview of levee crown at crossing.

Flap gate and concrete headwall visible on waterward side.

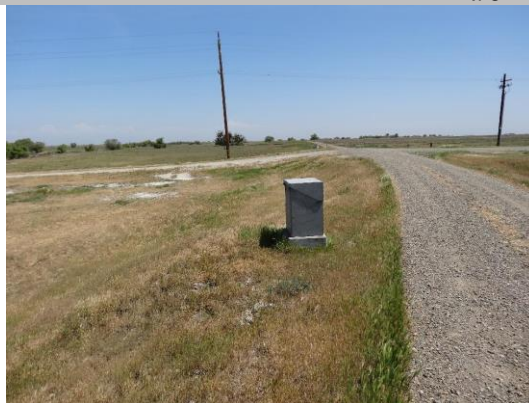
Photo 3 of 3 : UCIP_SP_2019_39482_71642.jpg

Comment Code						
Inspector Comment						
FS_ID:39482 DS_ID:19824 EP_NO: 6965 Repair Type: Non-Urgent Crossing Status: Indicator Found UCIP Comments: 04/18/2014 Description of structure does not match. Need to contact owner. Current description includes concrete platform, trash screen, and gage reading on waterward side. Metal box located on waterward shoulder. Large plant facility locate on landward side. (DWR UCIP - O. Magana) FIELD_STRUCT_DESC: 16-inch coated steel irrigation discharge pipe through the levee, 7.4 feet below the crown. Corrugated metal cutoff wall around the pipe in the center of the levee. Pump on the waterside (WS) with a timber platform on the berm for support. Siphon breaker on the apex of the pipe on the landside (LS) shoulder. Pipe exposed on both slopes. (Plans to place a 20-inch irrigation pipe through the levee authorized under Permit No. 6965, 1971 - Scarborough, Robinson, and Associates). [Additional Reference(s): DWR Levee Log, 2002]. FS Date: 4/10/2014

Metal box located on waterward shoulder.

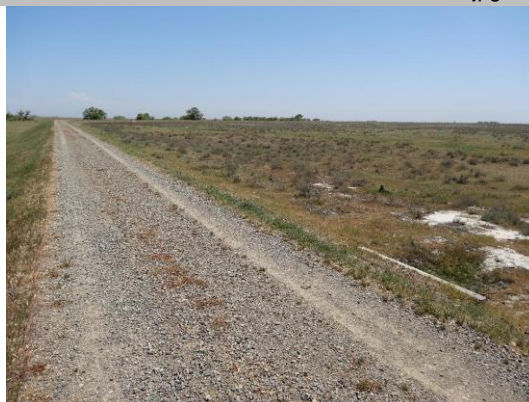
Photo 2 of 3 : UCIP_SP_2019_39466_66412.jpg

View of landward side.

Comment Code						
Inspector Comment						
FS_ID:39466 DS_ID:19826 EP_NO: N/A Repair Type: Non-Urgent Crossing Status: Found UCIP Comments: 04/18/2014 Sediment buildup inside crossing and is visible from landward side. Recommend clearing sediment buildup inside pipe and check wall integrity to determine condition. (DWR UCIP - O. Magana) FIELD_STRUCT_DESC: 24-inch corrugated metal gravity drainage pipe through the levee, 7 feet below the crown. Flap gate on the waterside (WS) end. Concrete headwall on each end. [Additional Reference(s): DWR Levee Log, 2002. USACE San Joaquin O&M Manual 601.1, 1967, (HLM 3.77)]. FS Date: 4/18/2014

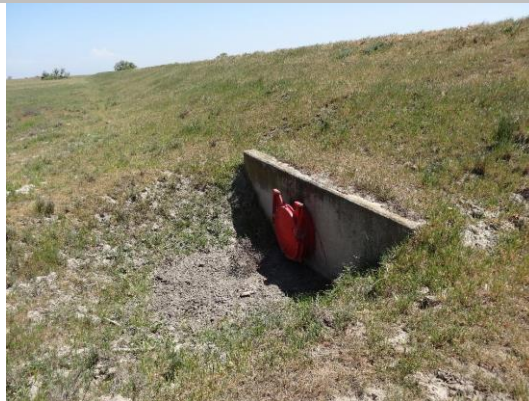
Photo 3 of 3 : UCIP_SP_2019_39466_66411.jpg

View of flap gate visible on waterward side.

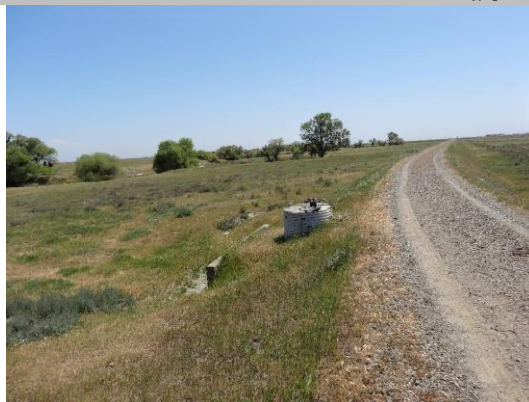
Photo 1 of 3 : UCIP_SP_2019_39467_66407.jpg

Comment Code						
Inspector Comment						
FS_ID:39467 DS_ID:19827 EP_NO: N/A Repair Type: Non-Urgent Crossing Status: Found UCIP Comments: 04/18/2014 Sediment buildup inside crossing and is visible from landward side. Recommend clearing sediment buildup inside pipe and check wall integrity to determine condition. (DWR UCIP - O. Magana) FIELD_STRUCT_DESC: 36-inch corrugated metal gravity drainage pipe through the levee, 6.7 feet below the crown. Slide gate in a 48-inch corrugated metal pipe (CMP) riser on the waterside (WS) slope. [Additional Reference(s): DWR Levee Log, 2002. USACE San Joaquin O&M Manual 601.1, 1967, (HLM 3.97)]. FS Date: 4/18/2014

View of waterward side.

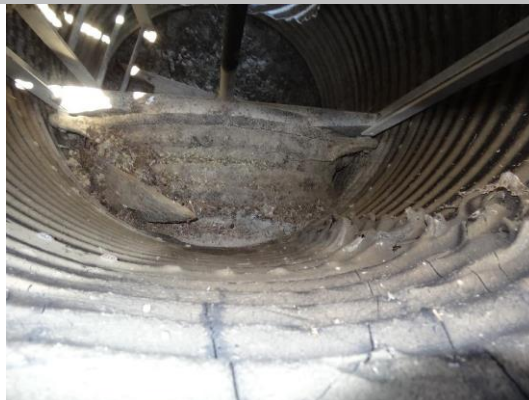
Photo 3 of 3 : UCIP_SP_2019_39467_66410.jpg

Inside view of CMP riser located on waterward side.

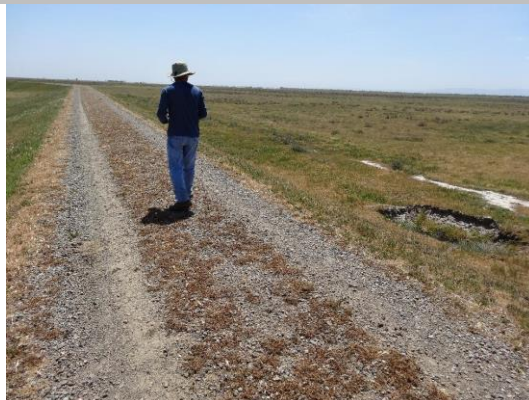
Photo 2 of 3 : UCIP_SP_2019_36606_66417.jpg

Overview of levee crown at crossing.

Comment Code						
Inspector Comment						
FS_ID:36606 DS_ID:19828 EP_NO: N/A Repair Type: Non-Urgent Crossing Status: Found UCIP Comments: 04/18/2014 Dense vegetation limits the inspector's visibility to identify signs of pipe condition on landward toe--headwall blocked by dense vegetation. Recommend removing vegetation from landward toe. (DWR UCIP - O. Magana) FIELD_STRUCT_DESC: 24-inch corrugated metal gravity drainage pipe through the levee, 10.8 feet below the crown. Flap gate on the waterside (WS) end. Concrete headwall on each end. [Additional Reference(s): DWR Levee Log, 2002. USACE San Joaquin O&M Manual 601.1, 1967, (HLM 4.17)]. FS Date: 4/18/2014

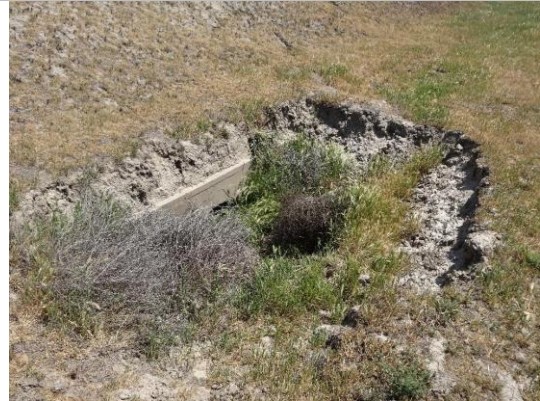
Photo 3 of 3 : UCIP_SP_2019_36606_66416.jpg

Concrete headwall visible on landward side.

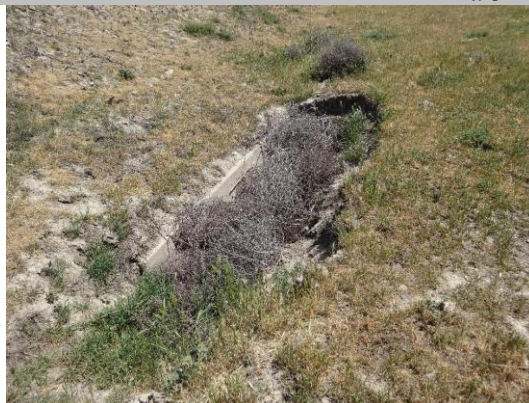
Photo 2 of 2 : UCIP_SP_2019_36607_66421.jpg

Comment Code						
Inspector Comment						
FS_ID:36607 DS_ID:19829 EP_NO: N/A Repair Type: Non-Urgent Crossing Status: Found UCIP Comments: 04/18/2014 Dense vegetation limits the inspector's visibility to identify signs of pipe condition on landward toe--headwall blocked by dense vegetation. Recommend removing vegetation from landward toe. (DWR UCIP - O. Magana) FIELD_STRUCT_DESC: 24-inch corrugated metal gravity drainage pipe through the levee, 11.3 feet below the crown. Flap gate on the waterside (WS) end. Concrete headwall on each end. [Additional Reference(s): DWR Levee Log, 2002. USACE San Joaquin O&M Manual 601.1, 1967, (HLM 4.41)]. FS Date: 4/18/2014

View of landward side--concrete headwall visible through dense vegetation.

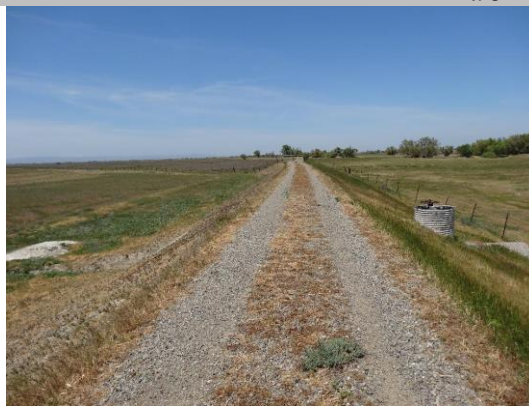
Photo 1 of 3 : UCIP_SP_2019_39468_66425.jpg

Comment Code					
Inspector Comment					
FS_ID:39468 DS_ID:19830 EP_NO: N/A Repair Type: Non-Urgent Crossing Status: Found UCIP Comments: 04/18/2014 Sediment buildup inside crossing visible from landward side. Recommend clearing sediment buildup inside pipe and check wall integrity to determine condition. (DWR UCIP - O. Magana) FIELD_STRUCT_DESC: 36-inch corrugated metal gravity drainage pipe through the levee, 6.9 feet below the crown. Slide gate in a 48-inch corrugated metal pipe (CMP) riser on the waterside (WS) slope. Concrete headwall on the landside (LS) end. Concrete saddle and apron on the WS end. [Additional Reference(s): DWR Levee Log, 2002. USACE San Joaquin O&M Manual 601.1, 1967, (HLM 4.70)]. FS Date: 4/18/2014

Overview of levee crown at crossing.

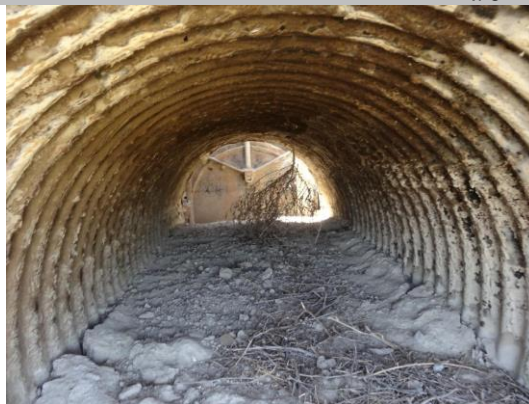
Photo 3 of 3 : UCIP_SP_2019_39468_66424.jpg

Inside view of pipe from waterward side.

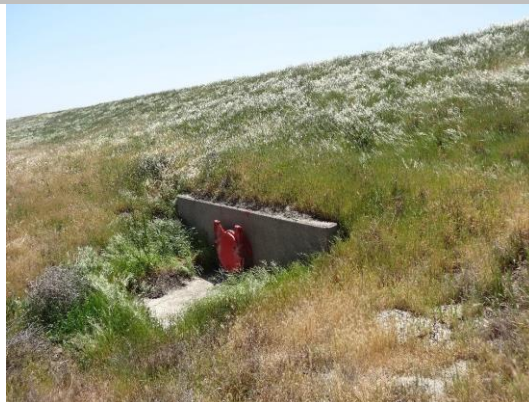
Photo 2 of 3 : UCIP_SP_2019_36609_66432.jpg

Flap gate, concrete headwall and apron visible on waterward toe.

Comment Code						
Inspector Comment						
FS_ID:36609						
DS_ID:19831						
EP_NO: N/A						
Repair Type: Non-Urgent						
Crossing Status: Found						
UCIP Comments: 04/18/2014 Need to contact owner. Recommend removing tall grass on landward toe to determine condition of crossing from landward side. (DWR UCIP - O. Magana)						
FIELD_STRUCT_DESC: 24-inch corrugated metal gravity drainage pipe through the levee, 11.8 feet below the crown. Flap gate on the waterside (WS) end. Concrete headwall on each end. [Additional Reference(s): DWR Levee Log, 2002. USACE San Joaquin O&M Manual 601.1, 1967, (HLM 4.75)].						
FS Date: 4/18/2014

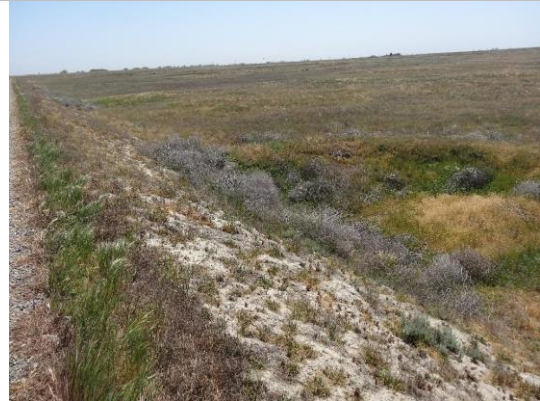
Photo 3 of 3 : UCIP_SP_2019_39875_61597.jpg

View of landward side.

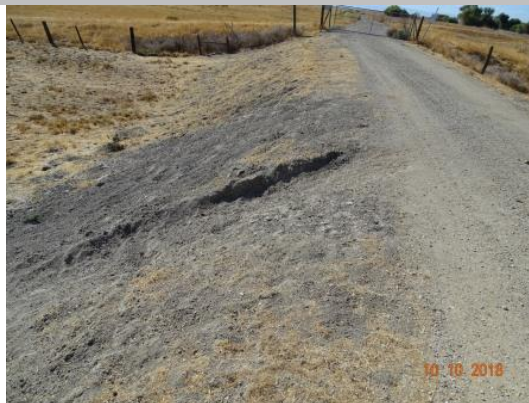
Photo 1 of 1 : SP_2019_NA0010_124_66_20190307_00016.jpg

LM Start	5.81	Rating **	M	Issue No.	66
LM End	5.81	Issue Type +	Ma	Location *	LS
Category	Earthen Levee			GPS Latitude/Longitude	
				Start	End
Item	Slope Stability			37.238189 °	37.238189 °
				-120.741946 °	-120.741946 °
DWR ID	DWR_NA0010_06_f_2017_66				
Comment Code					
S2 : Repair the levee slope damaged by foot traffic and prevent access where possible.					
Inspector Comment					
There is damage to the landside slope from livestock.

Damage from livestock. (Fall 2018)

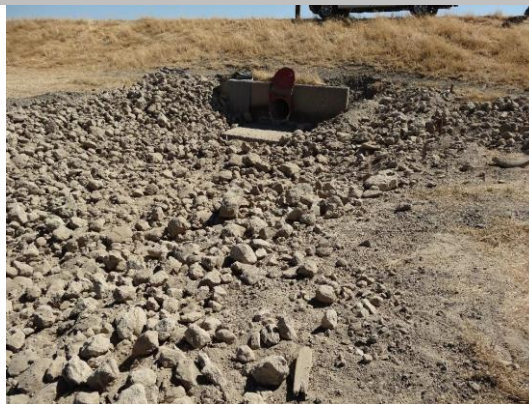
Photo 2 of 3 : UCIP_SP_2019_51312_75488.jpg

WS drainage path protected by rip rap.

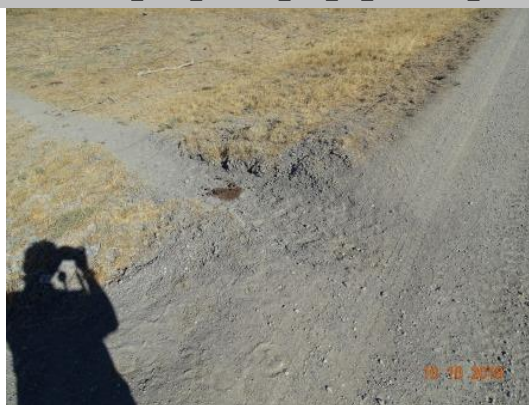
Photo 1 of 1 : SP_2019_NA0010_124_85_20190307_00033.jpg

LM Start	6.09	Rating **	M	Issue No.	85
LM End	6.09	Issue Type +	Ma	Location *	WS
Category	Earthen Levee			GPS Latitude/Longitude	
				Start	End
Item	Slope Stability			37.235572 °	37.235572 °
				-120.738002 °	-120.738002 °
DWR ID	DWR_NA0010_06_f_2018_85				
Comment Code					
S2 : Repair the levee slope damaged by foot traffic and prevent access where possible.					
Inspector Comment					
Livestock damage to slope and shoulder of levee.

View of livestock damage on waterside slope. (Fall 2018)

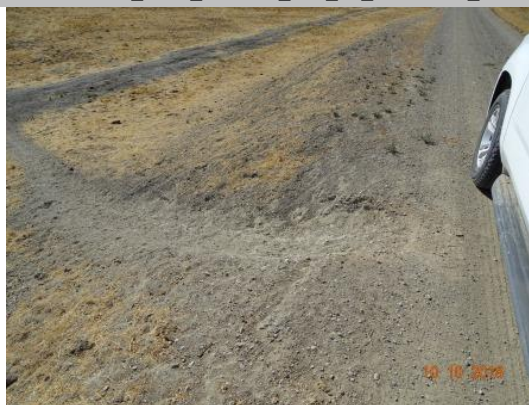
Photo 1 of 1 : SP_2019_NA0010_124_84_20190307_00032.jpg

LM Start	6.10	Rating **	M	Issue No.	84
LM End	6.10	Issue Type +	Ma	Location *	LS
Category	Earthen Levee			GPS Latitude/Longitude	
				Start	End
Item	Slope Stability			37.235570 °	37.235570 °
				-120.737998 °	-120.737998 °
DWR ID	DWR_NA0010_06_f_2018_84				
Comment Code					
S2 : Repair the levee slope damaged by foot traffic and prevent access where possible.					
Inspector Comment					
Damage to slope and crown from livestock.

Erosion to slope and into crown from livestock. (Fall 2018)

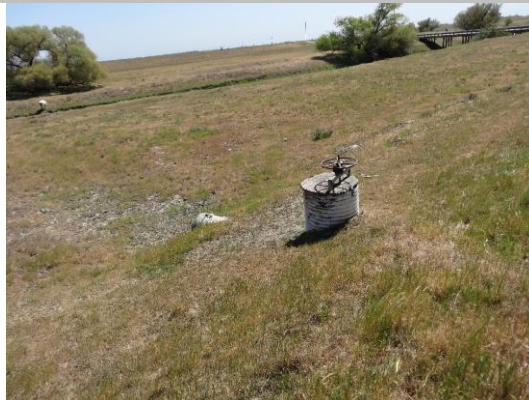
Photo 1 of 3 : UCIP_SP_2019_33984_61628.jpg

LM Start	6.70	Rating **	A/W	Issue No.	1233
LM End	6.70	Issue Type +	Ma	Location *	
Category	Supplemental			GPS Latitude/Longitude	
				Start	End
Item	DWR UCIP LMA Responsibility			37.230508 °	37.230508 °
				-120.729634 °	-120.729634 °
DWR ID	19866				
Comment Code					
Inspector Comment					
FS_ID:33984 DS_ID:19866 EP_NO: N/A Repair Type: No Action Needed Crossing Status: Found UCIP Comments: FIELD_STRUCT_DESC: 24-inch corrugated metal gravity drainage pipe through the levee, 7 feet below the crown. Slide gate in a 36-inch corrugated metal pipe (CMP) riser on the waterside (WS) slope. Concrete headwall on the landside (LS) end. Concrete saddle and apron on the WS end. [Additional Reference(s): DWR Levee Log, 2002. USACE San Joaquin O&M Manual 601.1, 1967, (HLM 6.79)]. FS Date: 4/18/2014

Slide gate inside CMP riser and pipe visible on waterward side.

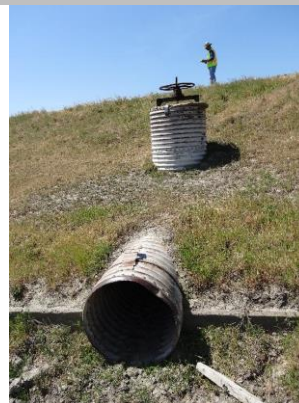
Photo 2 of 3 : UCIP_SP_2019_33984_61627.jpg

Concrete headwall visible on waterward side.

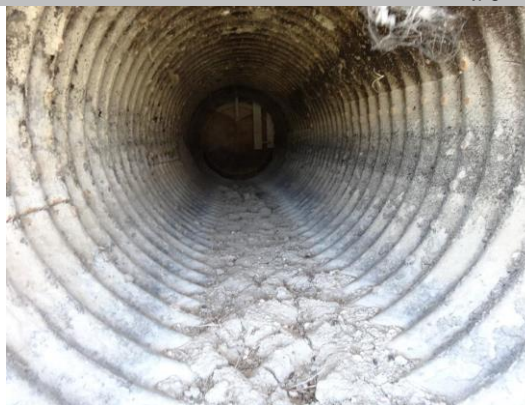
Photo 3 of 3 : UCIP_SP_2019_33984_61626.jpg

Inside view pipe from waterward side.

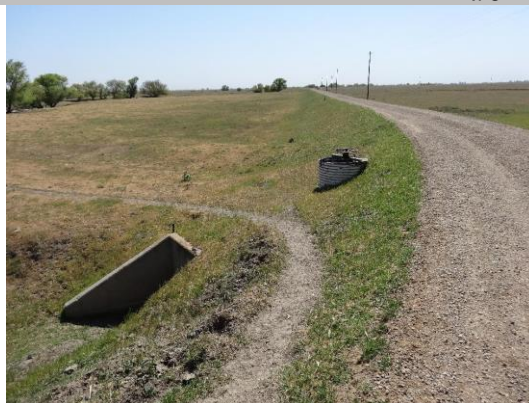
Photo 1 of 3 : UCIP_SP_2019_33985_61640.jpg

LM Start	6.89	Rating **	A/W	Issue No.	1234
LM End	6.89	Issue Type +	Ma	Location *	
Category	Supplemental			GPS Latitude/Longitude	
				Start	End
Item	DWR UCIP LMA Responsibility			37.228253 °	37.228253 °
				-120.727865 °	-120.727865 °
DWR ID	19867				
Comment Code					
Inspector Comment					
FS_ID:33985 DS_ID:19867 EP_NO: N/A Repair Type: No Action Needed Crossing Status: Found UCIP Comments: FIELD_STRUCT_DESC: 36-inch corrugated metal gravity drainage pipe through the levee, 10.7 feet below the crown. Slide gate in a 48-inch corrugated metal pipe (CMP) riser on the waterside (WS) slope. Concrete headwall on the landside (LS) end. Concrete U-shaped headwall on the WS end. [Additional Reference(s): DWR Levee Log, 2002. USACE San Joaquin O&M Manual 601.1, 1967, (HLM 6.97)]. FS Date: 4/18/2014

View of waterward side.

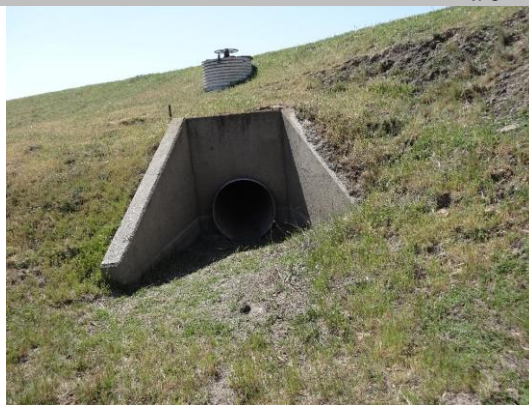
Photo 2 of 3 : UCIP_SP_2019_33985_61639.jpg

Concrete headwall and CMP riser visible on waterward side.

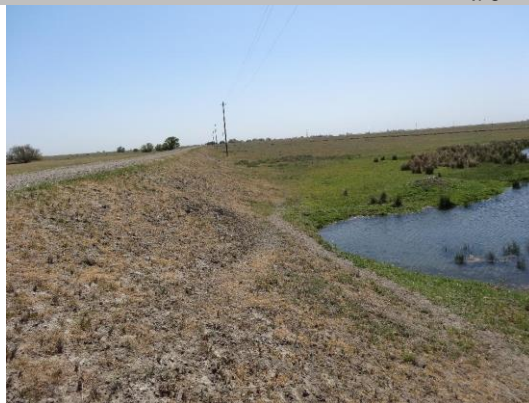
Photo 3 of 3 : UCIP_SP_2019_33985_61638.jpg

View of landward side.

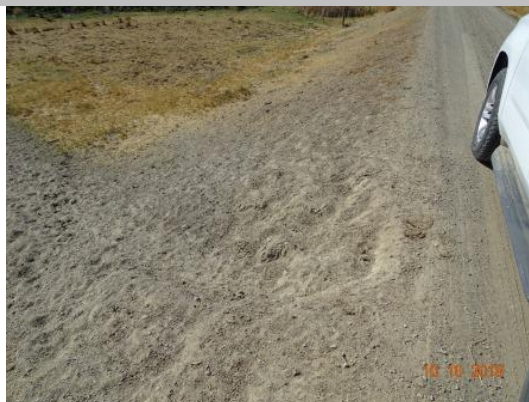
Photo 1 of 1 : SP_2019_NA0010_124_79_20190307_00027.jpg

LM Start	6.92	Rating **	M	Issue No.	79
LM End	6.92	Issue Type +	Ma	Location *	LS
Category	Earthen Levee			GPS Latitude/Longitude	
				Start	End
Item	Slope Stability			37.228054 °	37.228054 °
				-120.727428 °	-120.727428 °
DWR ID	DWR_NA0010_06_f_2018_79				
Comment Code					
S2 : Repair the levee slope damaged by foot traffic and prevent access where possible.					
Inspector Comment					
There is livestock damage to slope and shoulder of levee.

Damage to slope and shoulder from livestock. (Fall 2018)

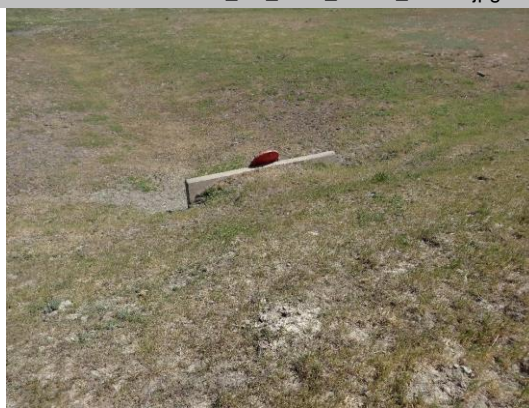
Photo 1 of 3 : UCIP_SP_2019_39471_61650.jpg

LM Start	7.21	Rating **	M	Issue No.	1235
LM End	7.21	Issue Type +	Ma	Location *	
Category	Supplemental			GPS Latitude/Longitude	
				Start	End
Item	DWR UCIP LMA Responsibility			37.226102 °	37.226102 °
				-120.722739 °	-120.722739 °
DWR ID	19868				
Comment Code					
Inspector Comment					
FS_ID:39471 DS_ID:19868 EP_NO: N/A Repair Type: Non-Urgent Crossing Status: Found UCIP Comments: 04/18/2014 Need to contact owner. Clear animal from waterward side. Some sediment buildup in pipe visible landward side--recommend clearing. (DWR UCIP - O. Magana) FIELD_STRUCT_DESC: 24-inch corrugated metal gravity drainage pipe through the levee, 10.6 feet below the crown. Flap gate on the waterside (WS) end. Concrete headwall on each end. [Additional Reference(s): DWR Levee Log, 2002. USACE San Joaquin O&M Manual 601.1, 1967, (HLM 7.29)]. FS Date: 4/18/2014

View of waterward side.

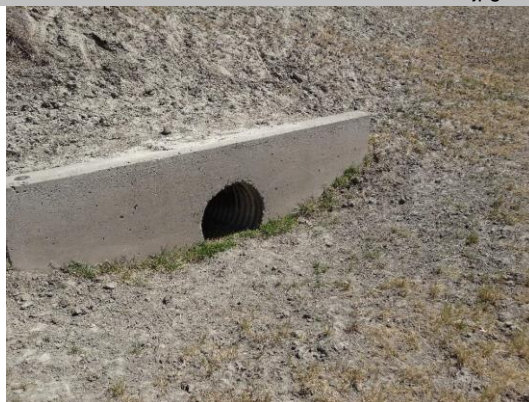
Photo 3 of 3 : UCIP_SP_2019_39471_61648.jpg

View of landward side.

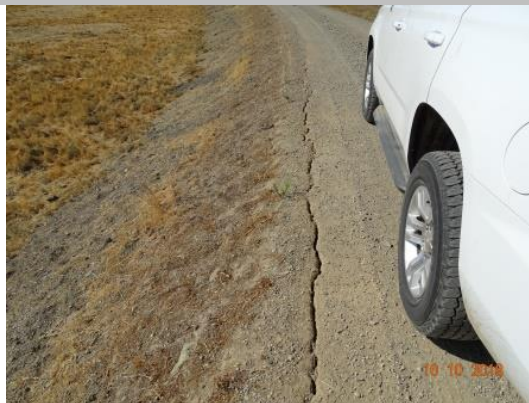
Photo 1 of 2 : SP_2019_NA0010_124_78_20190307_00025.jpg

LM Start	7.56	Rating **	A/W	Issue No.	78
LM End	7.56	Issue Type +	Ma	Location *	CR
Category	Earthen Levee			GPS Latitude/Longitude	
				Start	End
Item	Cracking			37.224113 °	37.224113 °
				-120.716887 °	-120.716887 °
DWR ID	DWR_NA0010_06_f_2018_78				
Comment Code					
CR1 : Monitor and have inspected by geotechnical engineer.					
Inspector Comment					
There is cracking along the landside shoulder of the crown.

View of crack along crown looking downstream.

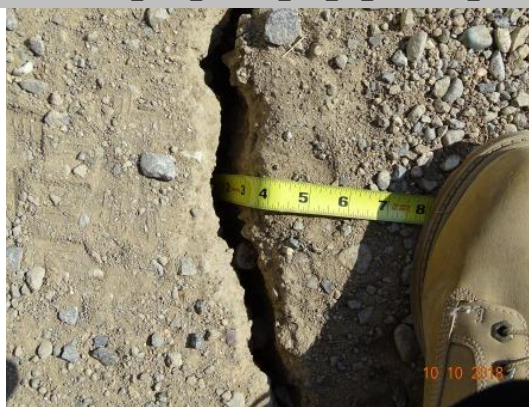
View of average depth of crack. (Fall 2018)

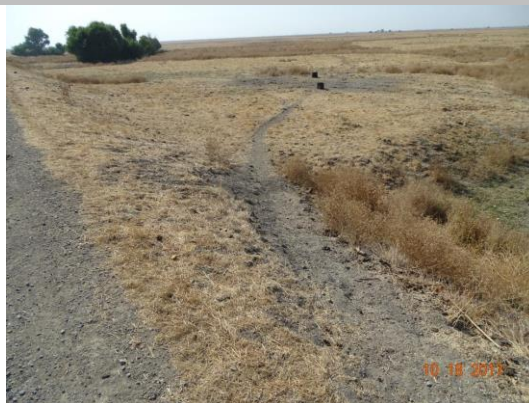
Photo 1 of 1 : SP_2019_NA0010_124_65_20190307_00015.jpg

LM Start	8.08	Rating **	M	Issue No.	65
LM End	8.08	Issue Type +	Ma	Location *	LS
Category	Earthen Levee			GPS Latitude/Longitude	
				Start	End
Item	Slope Stability			37.217199 °	37.217199 °
				-120.713374 °	-120.713374 °
DWR ID	DWR_NA0010_06_f_2017_65				
Comment Code					
S2 : Repair the levee slope damaged by foot traffic and prevent access where possible.					
Inspector Comment					
Livestock damage to levee slope.

Looking southwest at the landside slope.

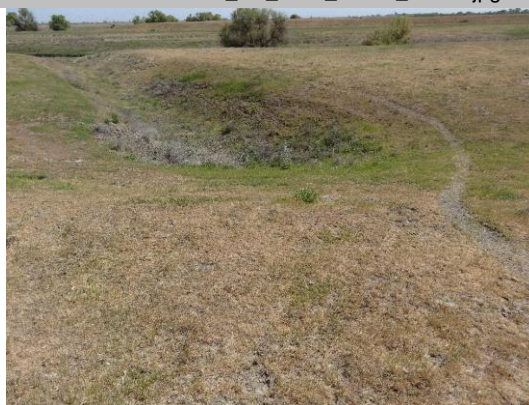
Photo 1 of 3 : UCIP_SP_2019_39473_61674.jpg

LM Start	8.13	Rating **	M	Issue No.	1237
LM End	8.13	Issue Type +	Ma	Location *	
Category	Supplemental			GPS Latitude/Longitude	
				Start	End
Item	DWR UCIP LMA Responsibility			37.216547 °	37.216547 °
				-120.713000 °	-120.713000 °
DWR ID	19870				
Comment Code					
Inspector Comment					
FS_ID:39473 DS_ID:19870 EP_NO: N/A Repair Type: Non-Urgent Crossing Status: Found UCIP Comments: 04/18/2014 Sediment buildup in pipe--recommend contacting owner to clear sediment. (DWR UCIP - O. Magana) FIELD_STRUCT_DESC: 24-inch corrugated metal gravity drainage pipe through the levee, 16.5 feet below the crown. Flap gate on the waterside (WS) end. Concrete headwall on each end. [Additional Reference(s): DWR Levee Log, 2002. USACE San Joaquin O&M Manual 601.1, 1967, (HLM 8.21)]. FS Date: 4/18/2014

View of waterward side.

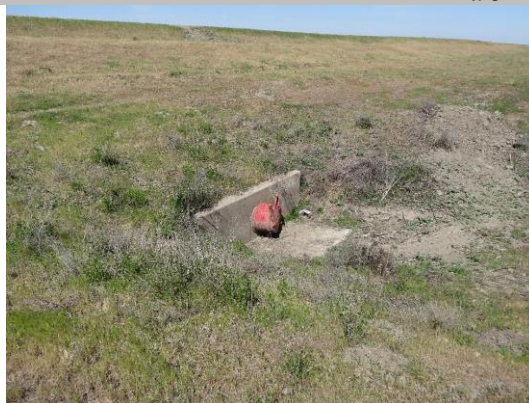
Photo 2 of 3 : UCIP_SP_2019_39473_61673.jpg

LM Start	8.13	Rating **	M	Issue No.	1237 (cont)	
LM End	8.13	Issue Type +	Ma	Location *		
Category	Supplemental			GPS Latitude/Longitude		
				Start	End	
Item	DWR UCIP LMA Responsibility			37.216547 °	37.216547 °	
				-120.713000 °	-120.713000 °	
DWR ID	19870					
Comment Code						
Inspector Comment						
FS_ID:39473 DS_ID:19870 EP_NO: N/A Repair Type: Non-Urgent Crossing Status: Found UCIP Comments: 04/18/2014 Sediment buildup in pipe--recommend contacting owner to clear sediment. (DWR UCIP - O. Magana) FIELD_STRUCT_DESC: 24-inch corrugated metal gravity drainage pipe through the levee, 16.5 feet below the crown. Flap gate on the waterside (WS) end. Concrete headwall on each end. [Additional Reference(s): DWR Levee Log, 2002. USACE San Joaquin O&M Manual 601.1, 1967, (HLM 8.21)]. FS Date: 4/18/2014

Pipe crosses levee at an angle.

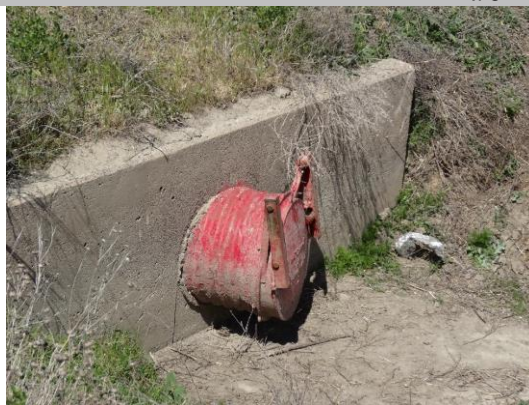
Photo 3 of 3 : UCIP_SP_2019_39473_61672.jpg

Concrete headwall and flap gate visible on waterward side.

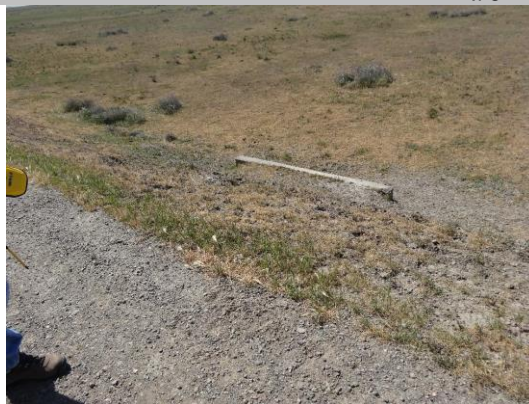
Photo 2 of 3 : UCIP_SP_2019_39474_61684.jpg

Comment Code					
Inspector Comment					
FS_ID:39474					
DS_ID:19871					
EP_NO: N/A					
Repair Type: Non-Urgent					
Crossing Status: Found					
UCIP Comments: 04/18/2014 Need to contact owner. Sediment buildup in pipe visible on landward side--recommend clearing. Good candidate for pressure test or video inspection due to signs of heavy corrosion. If no leaks after tests this crossing would be a good candidate for rehabilitation. (DWR UCIP - O. Magana)					
FIELD_STRUCT_DESC: 24-inch corrugated metal gravity drainage pipe through the levee, 9.2 feet below the crown. Flap gate on the waterside (WS) end. Concrete headwall on each end. [Additional Reference(s): DWR Levee Log, 2002. USACE San Joaquin O&M Manual 601.1, 1967, (HLM 8.51)].					
FS Date: 4/18/2014

View of landward side.

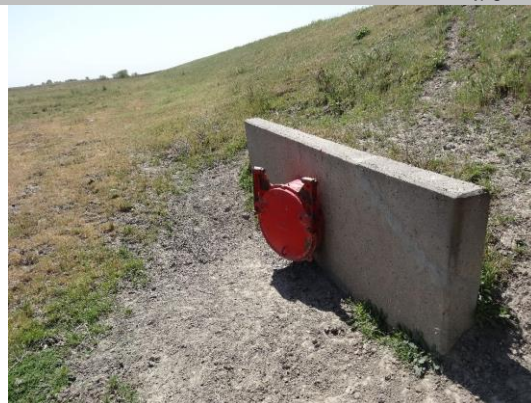
Photo 3 of 3 : UCIP_SP_2019_39474_61683.jpg

Comment Code						
Inspector Comment						
FS_ID:39474 DS_ID:19871 EP_NO: N/A Repair Type: Non-Urgent Crossing Status: Found UCIP Comments: 04/18/2014 Need to contact owner. Sediment buildup in pipe visible on landward side--recommend clearing. Good candidate for pressure test or video inspection due to signs of heavy corrosion. If no leaks after tests this crossing would be a good candidate for rehabilitation. (DWR UCIP - O. Magana) FIELD_STRUCT_DESC: 24-inch corrugated metal gravity drainage pipe through the levee, 9.2 feet below the crown. Flap gate on the waterside (WS) end. Concrete headwall on each end. [Additional Reference(s): DWR Levee Log, 2002. USACE San Joaquin O&M Manual 601.1, 1967, (HLM 8.51)]. FS Date: 4/18/2014

Pipe crosses levee at an angle.

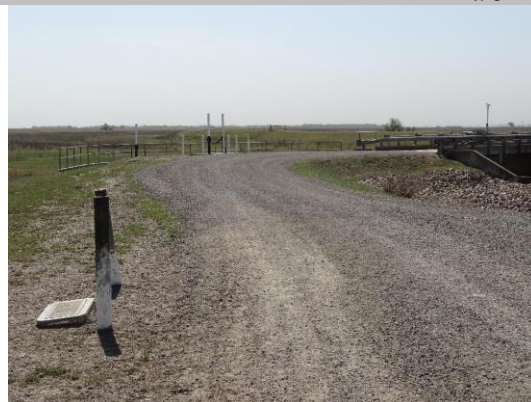
Photo 1 of 2 : UCIP_SP_2019_42525_72925.jpg

LM Start	9.52	Rating **	M	Issue No.	1239
LM End	9.52	Issue Type +	En	Location *	
Category	Supplemental			GPS Latitude/Longitude	
				Start	End
Item	DWR UCIP Field Study			37.202481 °	37.202481 °
				-120.695303 °	-120.695303 °
DWR ID	19872				
Comment Code					
Inspector Comment					
FS_ID:42525 DS_ID:19872 EP_NO: N/A Repair Type: Non-Urgent Crossing Status: Indicator Found UCIP Comments: 12/05/2014 Accidentally missed updating record. Photos have been added and coordinates have been updated. Unable to confirm if crossing is the same cable line originally identified in desk study at levee mile 6.43. Recommend contacting owner to confirm alignment, size of conduit, and permit issued. (DWR UCIP - O. Magana) FIELD_STRUCT_DESC: Telephone cable of an unknown size or material under crown of roadway, at an unknown depth. [Additional Reference(s): DWR Levee Log, 2002]. FS Date: 4/18/2014

Service box located on waterward levee shoulder.

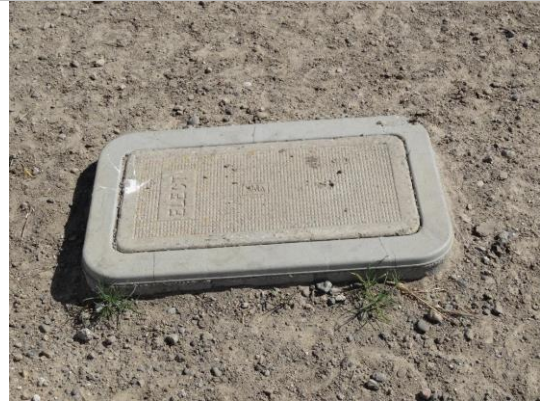
Photo 2 of 2 : UCIP_SP_2019_42525_72924.jpg

Comment Code						
Inspector Comment						
FS_ID:42525						
DS_ID:19872						
EP_NO: N/A						
Repair Type: Non-Urgent						
Crossing Status: Indicator Found						
UCIP Comments: 12/05/2014 Accidentally missed updating record.						
Photos have been added and coordinates have been updated. Unable						
to confirm if crossing is the same cable line originally identified in desk						
study at levee mile 6.43. Recommend contacting owner to confirm						
alignment, size of conduit, and permit issued. (DWR UCIP - O. Magana)						
FIELD_STRUCT_DESC: Telephone cable of an unknown size or						
material under crown of roadway, at an unknown depth. [Additional						
Reference(s): DWR Levee Log, 2002].						
FS Date: 4/18/2014

Service box is for electrical conduit.

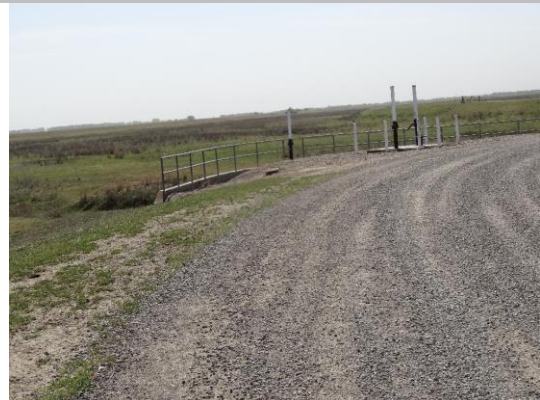
Photo 1 of 3 : UCIP_SP_2019_42524_72922.jpg

Comment Code						
Inspector Comment						
FS_ID:42524 DS_ID:19873 EP_NO: N/A Repair Type: Non-Urgent Crossing Status: Found UCIP Comments: 12/05/2014 Accidentally missed entry. Photos have been added and coordinates have been updated by Olivia Magana. Unable to determine condition of crossing due to limited access. Recommend contacting owner to provide condition of crossing. (DWR UCIP - O. Magana) FIELD_STRUCT_DESC: 36-inch corrugated metal gravity drainage pipe through the levee, 14 feet below the crown. Slide gate in a concrete diversion box on the waterside (WS) shoulder. [Additional Reference(s): DWR Levee Log, 2002]. FS Date: 4/18/2014

Overview of levee crown looking upstream.

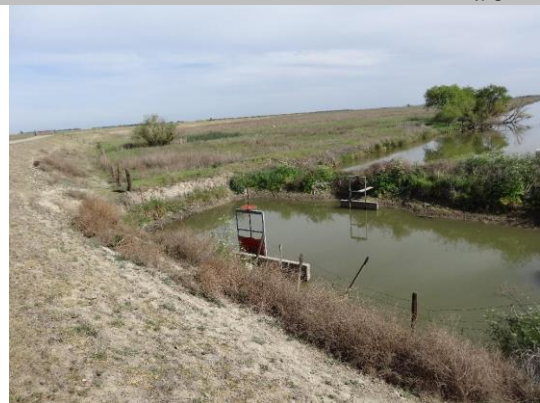
Photo 1 of 2 : UCIP_SP_2019_39475_61691.jpg

LM Start	9.66	Rating **	M	Issue No.	1246
LM End	9.66	Issue Type +	En	Location *	
Category	Supplemental			GPS Latitude/Longitude	
				Start	End
Item	DWR UCIP Field Study			37.200948 °	37.200948 °
				-120.694362 °	-120.694362 °
DWR ID	19874				
Comment Code					
Inspector Comment					
FS_ID:39475 DS_ID:19874 EP_NO: N/A Repair Type: Non-Urgent Crossing Status: Found UCIP Comments: 04/17/2014 Waterward side not visible--need to determine alignment. (DWR UCIP - O. Magana) FIELD_STRUCT_DESC: 36-inch corrugated metal gravity drainage pipe through the levee, 14 feet below the crown. Slide gate in a concrete diversion box on the waterside (WS) shoulder. [Additional Reference(s): DWR Levee Log, 2002]. FS Date: 4/17/2014

View of landward side.

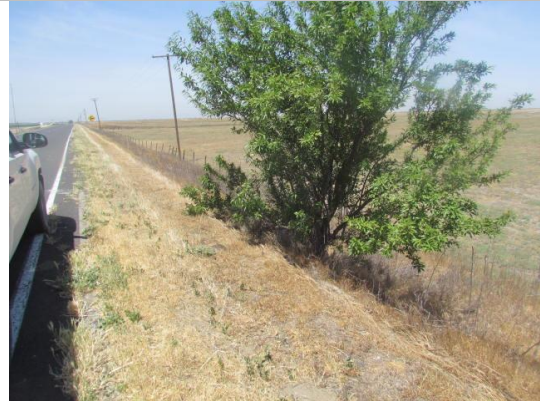
Photo 1 of 1 : SP_2019_NA0010_124_14_20190307_00014.jpg

LM Start	11.49	Rating **	M	Issue No.	14
LM End	11.49	Issue Type +	Ma	Location *	WS
Category	Earthen Levee			GPS Latitude/Longitude	
				Start	End
Item	Trim / Thin Trees			37.186189 °	37.186189 °
				-120.668476 °	-120.668476 °
DWR ID	DWR_NA0010_06_s_2015_14				
Comment Code					
T1 : Trim trees to at least five feet above ground level.					
Inspector Comment					
Almond tree located along Sandy Mush Road on waterside slope.

Looking west at tree on waterward slope.

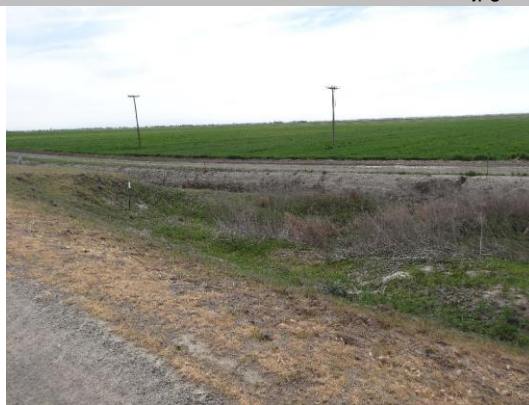
Photo 2 of 3 : UCIP_SP_2019_39476_66487.jpg

LM Start	11.74	Rating **	M	Issue No.	1248
LM End	11.74	Issue Type +	Ma	Location *	
Category	Supplemental			GPS Latitude/Longitude	
				Start	End
Item	DWR UCIP LMA Responsibility			37.185513 °	37.185513 °
				-120.664561 °	-120.664561 °
DWR ID	19876				
Comment Code					
Inspector Comment					
FS_ID:39476					
DS_ID:19876					
EP_NO: N/A					
Repair Type: Non-Urgent					
Crossing Status: Found					
UCIP Comments: 04/17/2014 Clear debris from waterward and landward toes. (DWR UCIP - O. Magana)					
FIELD_STRUCT_DESC: 36-inch corrugated metal gravity drainage pipe through the levee, 17 feet below the crown. Slide gate in a pipe riser on the waterside (WS) slope. [Additional Reference(s): DWR Levee Log, 2002. USACE San Joaquin O&M Manual 601.1, 1967, (HLM 11.82)].					
FS Date: 4/17/2014

View of landward side.

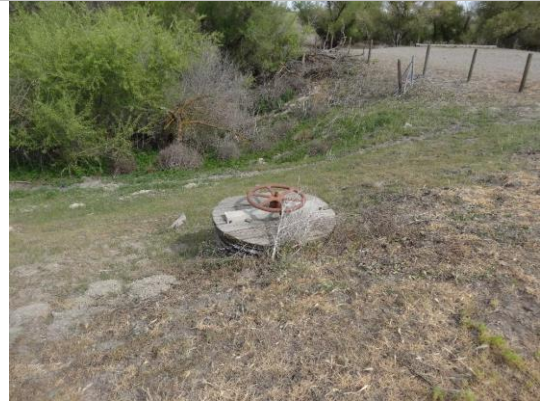
Photo 3 of 3 : UCIP_SP_2019_39476_66486.jpg

LM Start	11.74	Rating **	M	Issue No.	1248 (cont)	
LM End	11.74	Issue Type +	Ma	Location *		
Category	Supplemental			GPS Latitude/Longitude		
				Start	End	
Item	DWR UCIP LMA Responsibility			37.185513 °	37.185513 °	
				-120.664561 °	-120.664561 °	
DWR ID	19876					
Comment Code						
Inspector Comment						
FS_ID:39476						
DS_ID:19876						
EP_NO: N/A						
Repair Type: Non-Urgent						
Crossing Status: Found						
UCIP Comments: 04/17/2014 Clear debris from waterward and landward toes. (DWR UCIP - O. Magana)						
FIELD_STRUCT_DESC: 36-inch corrugated metal gravity drainage pipe through the levee, 17 feet below the crown. Slide gate in a pipe riser on the waterside (WS) slope. [Additional Reference(s): DWR Levee Log, 2002. USACE San Joaquin O&M Manual 601.1, 1967, (HLM 11.82)].						
FS Date: 4/17/2014

Slide gate inside CMP riser located on waterward slope.

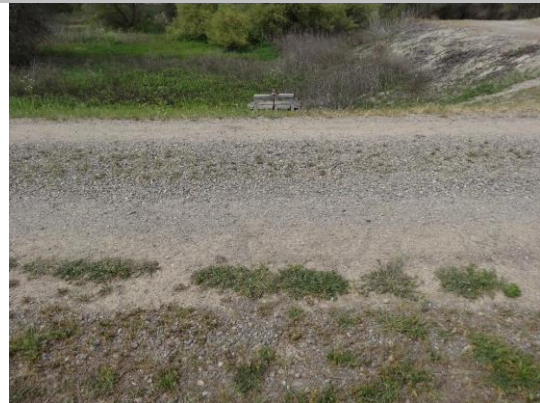
Photo 1 of 3 : UCIP_SP_2019_39477_66492.jpg

LM Start	13.22	Rating **	M	Issue No.	1249
LM End	13.22	Issue Type +	Ma	Location *	
Category	Supplemental			GPS Latitude/Longitude	
				Start	End
Item	DWR UCIP LMA Responsibility			37.171675 °	37.171675 °
				-120.655064 °	-120.655064 °
DWR ID	19877				
Comment Code					
Inspector Comment					
FS_ID:39477 DS_ID:19877 EP_NO: N/A Repair Type: Non-Urgent Crossing Status: Found UCIP Comments: 04/17/2014 Not accessible--crossing is buried on landward side. Need to contact owner to determine status. (DWR UCIP - O. Magana) FIELD_STRUCT_DESC: 24-inch corrugated metal gravity drainage pipe through the levee, 10.8 feet below the crown. Flap gate on the waterside (WS) end. [Additional Reference(s): DWR Levee Log, 2002. USACE San Joaquin O&M Manual 601.1, 1967, (HLM 13.30)]. FS Date: 4/17/2014

View of levee crown at crossing.

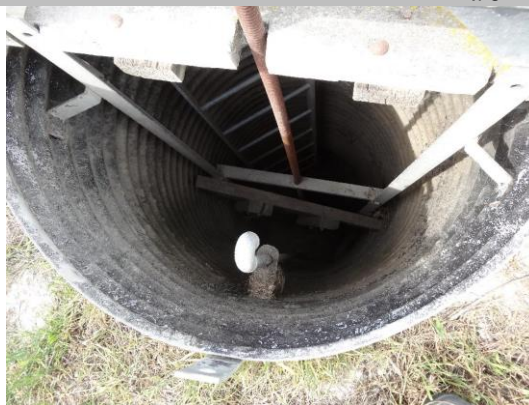
Photo 3 of 3 : UCIP_SP_2019_39477_66495.jpg

LM Start	13.22	Rating **	M	Issue No.	1249 (cont)
LM End	13.22	Issue Type +	Ma	Location *	
Category	Supplemental			GPS Latitude/Longitude	
				Start	End
Item	DWR UCIP LMA Responsibility			37.171675 °	37.171675 °
				-120.655064 °	-120.655064 °
DWR ID	19877				
Comment Code					
Inspector Comment					
FS_ID:39477 DS_ID:19877 EP_NO: N/A Repair Type: Non-Urgent Crossing Status: Found UCIP Comments: 04/17/2014 Not accessible--crossing is buried on landward side. Need to contact owner to determine status. (DWR UCIP - O. Magana) FIELD_STRUCT_DESC: 24-inch corrugated metal gravity drainage pipe through the levee, 10.8 feet below the crown. Flap gate on the waterside (WS) end. [Additional Reference(s): DWR Levee Log, 2002. USACE San Joaquin O&M Manual 601.1, 1967, (HLM 13.30)]. FS Date: 4/17/2014

Inside view of CMP riser located on waterward slope.

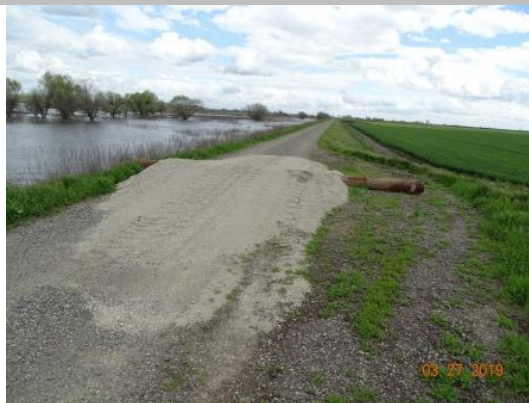
Photo 1 of 2 : SP_2019_NA0010_124_116_20190418_00193.jpg

LM Start	13.48	Rating **	U	Issue No.	116
LM End	13.48	Issue Type +	En	Location *	CR
Category	Earthen Levee			GPS Latitude/Longitude	
				Start	End
Item	Encroachments			37.171651 °	37.171651 °
				-120.650354 °	-120.650354 °
DWR ID	DWR_NA0010_06_s_2019_116				
Comment Code					
PI : Pipe					
Inspector Comment					
Landowner or farmer installed a pipe across levee crown.

View of pipe encroachment looking upstream. (Spring 2019)

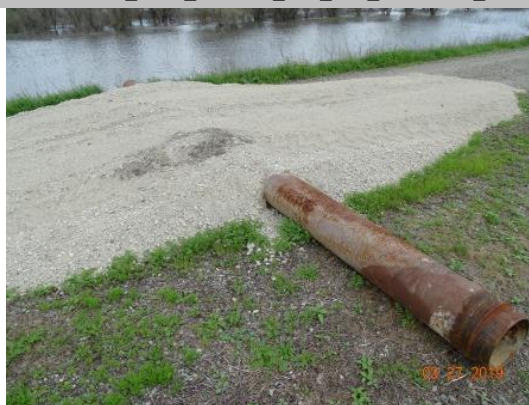
Photo 2 of 2 : SP_2019_NA0010_124_116_20190418_00194.jpg

View of pipe encroachment looking East. (Spring 2019)

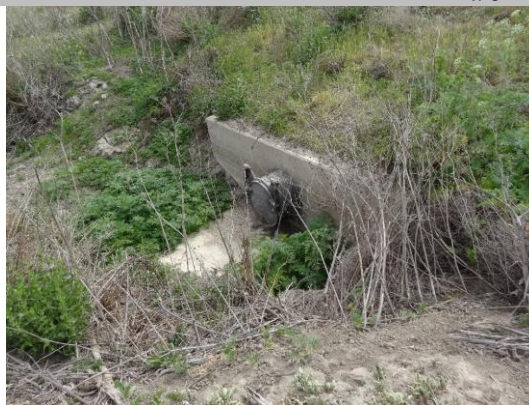
Photo 2 of 3 : UCIP_SP_2019_39478_66497.jpg

LM Start	14.36	Rating **	M	Issue No.	1250
LM End	14.36	Issue Type +	Ma	Location *	
Category	Supplemental			GPS Latitude/Longitude	
				Start	End
Item	DWR UCIP LMA Responsibility			37.167888 °	37.167888 °
				-120.636419 °	-120.636419 °
DWR ID	19878				
Comment Code					
Inspector Comment					
FS_ID:39478 DS_ID:19878 EP_NO: N/A Repair Type: Non-Urgent Crossing Status: Found UCIP Comments: 04/17/2014 Not accessible--crossing is buried on landward side. Need to contact owner to determine status. (DWR UCIP - O. Magana) FIELD_STRUCT_DESC: 24-inch corrugated metal gravity drainage pipe through the levee, 12.3 feet below the crown. Flap gate on the waterside (WS) end. [Additional Reference(s): DWR Levee Log, 2002. USACE San Joaquin O&M Manual 601.1, 1967, (HLM 14.44)]. FS Date: 4/17/2014

View of pipe daylight, flap gate, and concrete headwall visible on waterward toe.

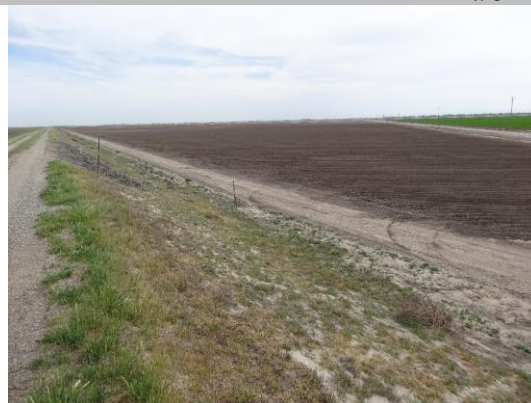
Photo 3 of 3 : UCIP_SP_2019_39478_66498.jpg

LM Start	14.36	Rating **	M	Issue No.	1250 (cont)
LM End	14.36	Issue Type +	Ma	Location *	
Category	Supplemental			GPS Latitude/Longitude	
				Start	End
Item	DWR UCIP LMA Responsibility			37.167888 °	37.167888 °
				-120.636419 °	-120.636419 °
DWR ID	19878				
Comment Code					
Inspector Comment					
FS_ID:39478 DS_ID:19878 EP_NO: N/A Repair Type: Non-Urgent Crossing Status: Found UCIP Comments: 04/17/2014 Not accessible--crossing is buried on landward side. Need to contact owner to determine status. (DWR UCIP - O. Magana) FIELD_STRUCT_DESC: 24-inch corrugated metal gravity drainage pipe through the levee, 12.3 feet below the crown. Flap gate on the waterside (WS) end. [Additional Reference(s): DWR Levee Log, 2002. USACE San Joaquin O&M Manual 601.1, 1967, (HLM 14.44)]. FS Date: 4/17/2014

View of landward slope.

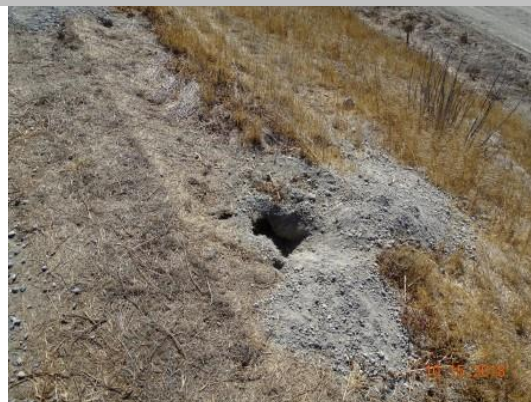
Photo 1 of 1 : SP_2019_NA0010_124_101_20190307_00043.jpg

LM Start	14.63	Rating **	M	Issue No.	101
LM End	14.64	Issue Type +	Ma	Location *	LS
Category	Earthen Levee			GPS Latitude/Longitude	
				Start	End
Item	Animal Control			37.164871 °	37.164824 °
				-120.633222 °	-120.633167 °
DWR ID	DWR_NA0010_06_f_2018_101				
Comment Code					
A3 : No rodents visible, but rodent burrows visible; need to backfill and compact or grout burrows.					
Inspector Comment					
Burrows are located along landside shoulder.

View of rodent hole on landside shoulder. (Fall 2018)

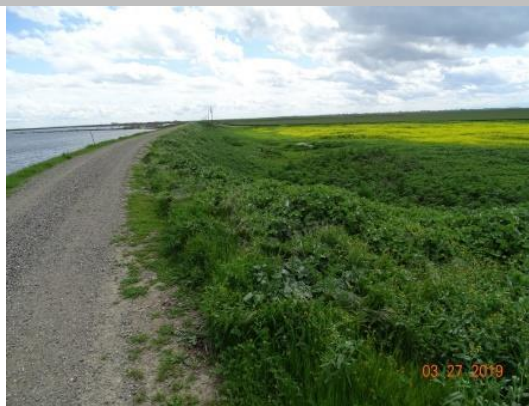
Photo 1 of 1 : SP_2019_NA0010_124_104_20190418_00195.jpg

LM Start	15.50	Rating **	U	Issue No.	104
LM End	15.74	Issue Type +	Ma	Location *	LS
Category	Earthen Levee			GPS Latitude/Longitude	
				Start	End
Item	Vegetation			37.158632 °	37.156358 °
				-120.619631 °	-120.616420 °
DWR ID	DWR_NA0010_06_f_2018_104				
Comment Code					
V1 : Control annual grass and weeds on the levee slopes and easements.					
Inspector Comment

View of vegetation on landside slope looking upstream. (Spring 2019)

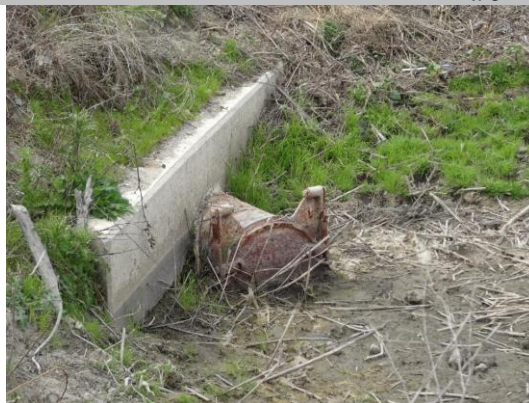
Photo 1 of 3 : UCIP_SP_2019_39480_66507.jpg

LM Start	15.68	Rating **	M	Issue No.	1251	
LM End	15.68	Issue Type +	Ma	Location *		
Category	Supplemental			GPS Latitude/Longitude		
				Start		End
Item	DWR UCIP LMA Responsibility			37.156934 °	37.156934 °	
				-120.617210 °	-120.617210 °	
DWR ID	19884					
Comment Code						
Inspector Comment						
FS_ID:39480 DS_ID:19884 EP_NO: N/A Repair Type: Non-Urgent Crossing Status: Found UCIP Comments: 04/17/2014 Need to contact owner. Sediment buildup on both the waterward and landward side. Recommend removing sediment buildup from both side. Also recommend clearing excess sediment inside crossing. (DWR UCIP - O. Magana) FIELD_STRUCT_DESC: 24-inch corrugated metal gravity drainage pipe through the levee, 14 feet below the crown. Flap gate on the waterside (WS) end. [Additional Reference(s): DWR Levee Log, 2002. USACE San Joaquin O&M Manual 601.1, 1967, (HLM 15.76)]. FS Date: 4/17/2014

Flap gate buried halfway on waterward side.

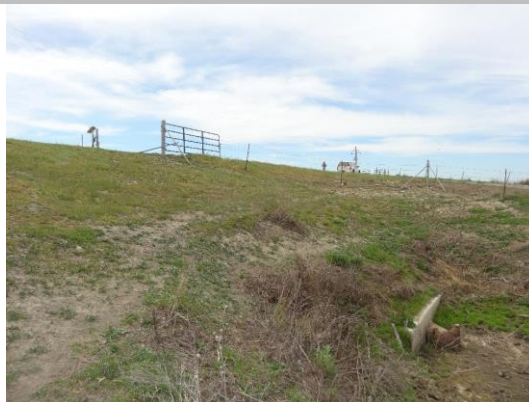
Photo 2 of 3 : UCIP_SP_2019_39480_66506.jpg

View of waterward side.

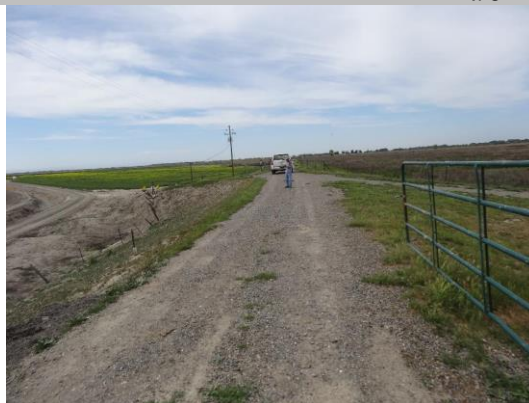
Photo 3 of 3 : UCIP_SP_2019_39480_66505.jpg

Item	DWR UCIP LMA Responsibility			37.156934 °	37.156934 °	
				-120.617210 °	-120.617210 °	
DWR ID	19884					
Comment Code						
Inspector Comment						
FS_ID:39480 DS_ID:19884 EP_NO: N/A Repair Type: Non-Urgent Crossing Status: Found UCIP Comments: 04/17/2014 Need to contact owner. Sediment buildup on both the waterward and landward side. Recommend removing sediment buildup from both side. Also recommend clearing excess sediment inside crossing. (DWR UCIP - O. Magana) FIELD_STRUCT_DESC: 24-inch corrugated metal gravity drainage pipe through the levee, 14 feet below the crown. Flap gate on the waterside (WS) end. [Additional Reference(s): DWR Levee Log, 2002. USACE San Joaquin O&M Manual 601.1, 1967, (HLM 15.76)]. FS Date: 4/17/2014

Overview of levee crown at crossing.

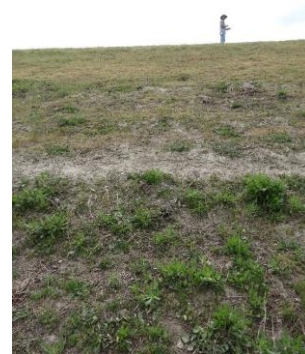
Photo 1 of 3 : UCIP_SP_2019_36663_66530.jpg

Comment Code						
Inspector Comment						
FS_ID:36663						
DS_ID:19885						
EP_NO: N/A						
Repair Type: Non-Urgent						
Crossing Status: Found						
UCIP Comments: 04/17/2014 Need to contact owner to determine status of crossing. Waterward side is buried and not accessible. Landward side headwall is blocked by dense vegetation. Recommend confirming status of flap gate on waterward side and removing dense vegetation form landward side. (DWR UCIP - O. Magana)						
FIELD_STRUCT_DESC: 36-inch corrugated metal gravity drainage pipe through the levee, 16.6 feet below the crown. Flap gate on the waterside (WS) end. [Additional Reference(s): DWR Levee Log, 2002. USACE San Joaquin O&M Manual 601.1, 1967, (HLM 15.91)].						
FS Date: 4/17/2014

View of waterward side, Photo 1 of 3.

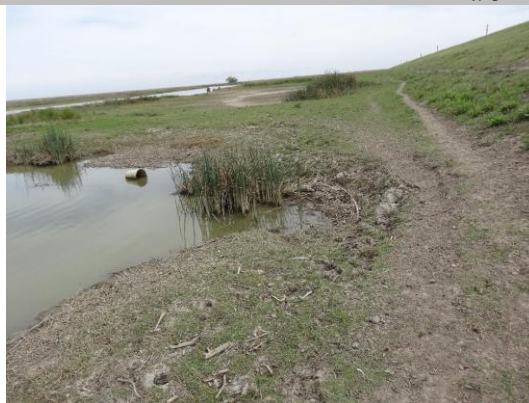
Photo 2 of 3 : UCIP_SP_2019_36663_66526.jpg

Item	DWR UCIP LMA Responsibility			37.155539 °		37.155539 °
				-120.615303 °		-120.615303 °
DWR ID	19885					
Comment Code						
Inspector Comment						
FS_ID:36663 DS_ID:19885 EP_NO: N/A Repair Type: Non-Urgent Crossing Status: Found UCIP Comments: 04/17/2014 Need to contact owner to determine status of crossing. Waterward side is buried and not accessible. Landward side headwall is blocked by dense vegetation. Recommend confirming status of flap gate on waterward side and removing dense vegetation form landward side. (DWR UCIP - O. Magana) FIELD_STRUCT_DESC: 36-inch corrugated metal gravity drainage pipe through the levee, 16.6 feet below the crown. Flap gate on the waterside (WS) end. [Additional Reference(s): DWR Levee Log, 2002. USACE San Joaquin O&M Manual 601.1, 1967, (HLM 15.91)]. FS Date: 4/17/2014

View of waterward side, photo 2 of 3.

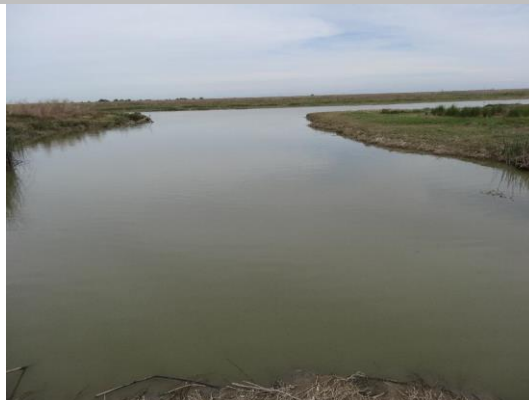
Photo 3 of 3 : UCIP_SP_2019_36663_66529.jpg

View of waterward side, photo 3 of 3.
