**Flood Control Project Maintenance
Levee Inspections**
LMA District Cover Sheet
Spring 2019 Levee Inspection Results

Lower San Joaquin Levee District

Spring 2019 Levee Inspection Results

Waterway			Bank	Unit Miles
Unit No. 01 San Joaquin River			Right	22.52
	Spring (March - May)	Summer (June - August)	(September - November) Fall	Winter (December - February)
Unit Maintenance Rating (Fall Only)				
Date of Inspection	3/26/2019 - 3/26/2019			
DWR Inspector	Corey Fujitani			
Accompanied By

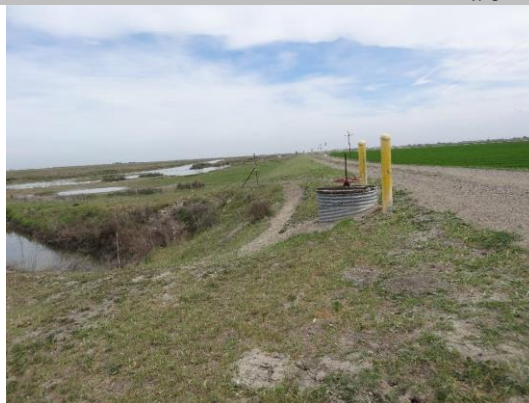
Photo 1 of 3 : UCIP_SP_2019_36665_66541.jpg

LM Start	16.40	Rating **	M	Issue No.	1253
LM End	16.40	Issue Type +	En	Location *	
Category	Supplemental			GPS Latitude/Longitude	
				Start	End
Item	DWR UCIP Field Study			37.149747 °	37.149747 °
				-120.607702 °	-120.607702 °
DWR ID	19559				
Comment Code					
Inspector Comment					
FS_ID:36665 DS_ID:19559 EP_NO: N/A Repair Type: Non-Urgent Crossing Status: Found UCIP Comments: 04/17/2014 Need to contact owner to determine status of crossing. Unable to confirm pipe diameter. (DWR UCIP - O. Magana) FIELD_STRUCT_DESC: 36-inch corrugated metal irrigation siphon pipe through the levee, 5.9 feet below the crown. Slide gate on the waterside (WS). Siphon extends under channel. [Additional Reference(s): USACE San Joaquin O&M Manual 601.1, 1967, (HLM 16.49)]. FS Date: 4/17/2014

View of waterward side.

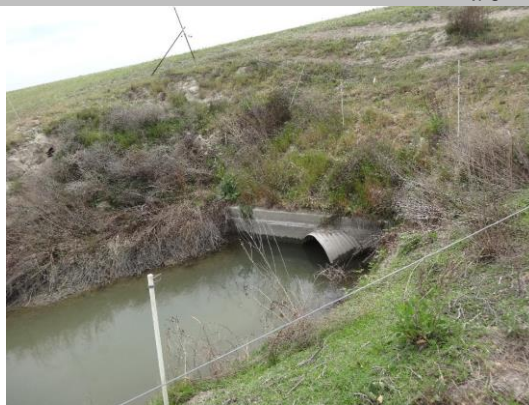
Photo 2 of 3 : UCIP_SP_2019_36665_66539.jpg

Concrete headwall and pipe visible on waterward side.

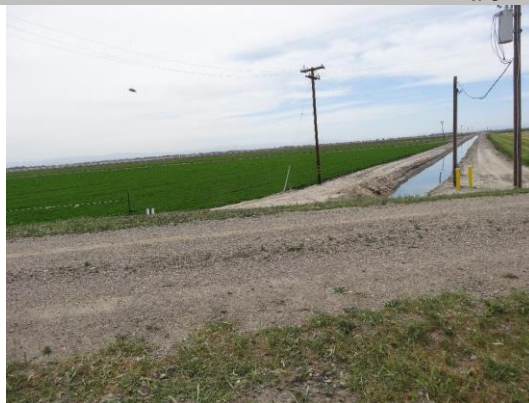
Photo 3 of 3 : UCIP_SP_2019_36665_66540.jpg

LM Start	16.40	Rating **	M	Issue No.	1253 (cont)	
LM End	16.40	Issue Type +	En	Location *		
Category	Supplemental			GPS Latitude/Longitude		
				Start		End
Item	DWR UCIP Field Study			37.149747 °		37.149747 °
				-120.607702 °		-120.607702 °
DWR ID	19559					
Comment Code						
Inspector Comment						
FS_ID:36665 DS_ID:19559 EP_NO: N/A Repair Type: Non-Urgent Crossing Status: Found UCIP Comments: 04/17/2014 Need to contact owner to determine status of crossing. Unable to confirm pipe diameter. (DWR UCIP - O. Magana) FIELD_STRUCT_DESC: 36-inch corrugated metal irrigation siphon pipe through the levee, 5.9 feet below the crown. Slide gate on the waterside (WS). Siphon extends under channel. [Additional Reference(s): USACE San Joaquin O&M Manual 601.1, 1967, (HLM 16.49)]. FS Date: 4/17/2014

View of landward side, photo 1 of 2.

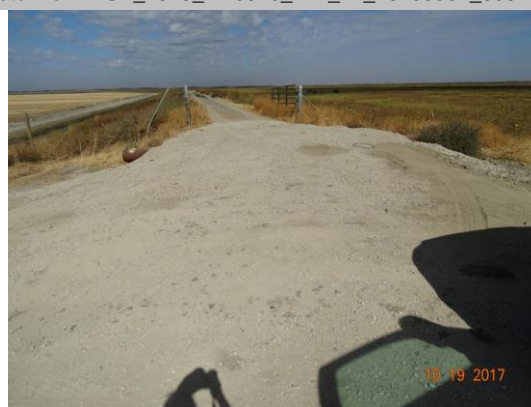
Photo 1 of 1 : SP_2019_NA0010_124_72_20190307_00022.jpg

LM Start	18.18	Rating **	U	Issue No.	72
LM End	18.18	Issue Type +	En	Location *	CR
Category	Earthen Levee			GPS Latitude/Longitude	
				Start	End
Item	Encroachments			37.127982 °	37.127982 °
				-120.590911 °	-120.590911 °
DWR ID	DWR_NA0010_06_f_2017_72				
Comment Code					
PI : Pipe					
Inspector Comment					
Non permitted pipe across the levee crown.

Looking northwest at the pipe across the levee crown.

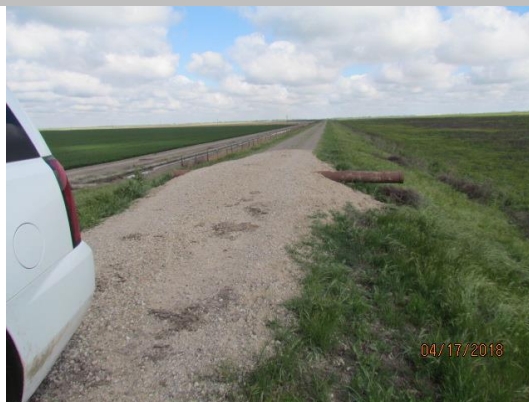
Photo 1 of 1 : SP_2019_NA0010_124_70_20190307_00021.jpg

LM Start	18.46	Rating **	U	Issue No.	70
LM End	18.46	Issue Type +	En	Location *	CR
Category	Earthen Levee			GPS Latitude/Longitude	
				Start	End
Item	Encroachments			37.124088 °	37.124088 °
				-120.589249 °	-120.589249 °
DWR ID	DWR_NA0010_06_s_2018_70				
Comment Code					
PI : Pipe					
Inspector Comment					
Landowner or farmer installed a pipe across levee crown.

Looking south at pipe across levee crown. (Spring 2018)

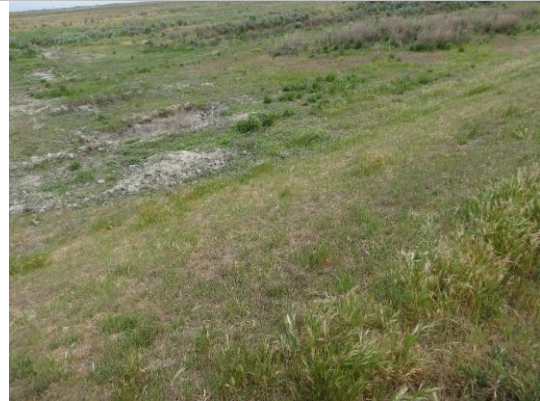
Photo 1 of 3 : UCIP_SP_2019_53191_66562.jpg

Comment Code						
Inspector Comment						
FS_ID:53191 DS_ID:19888 EP_NO: 3040 Repair Type: Urgent Crossing Status: Found UCIP Comments: 11/01/2018 Signs of pipe leakage (wet spot) visible in floodway. Crossing remains Urgent due to potential leakage along the pipe. Recommend internal inspection to determine pipe integrity through the levee. (O. Magana - DWR UCIP)07/20/2016 Same as previous inspection. Dense vegetation prevents proper inspection along floodway. (DWR UCIP - omagana)04/17/2014 Need to contact owner. Leak on waterward toe approximately 15 feet from toe. Good candidate for video or pressure test. (DWR UCIP - omagana) FIELD_STRUCT_DESC: 48-inch corrugated metal irrigation siphon pipe through the levee, 8.8 feet below the crown. Slide gate in a pipe riser on the landside (LS) slope, not the waterside (WS) slope. Concrete headwall on the LS, not the WS. Siphon extends under the channel. 24-inch corrugated metal cleanout pipe at the center of the channel with a metal plate cover. (Plans for construction of two reinforced concrete siphons across the Eastside Bypass authorized under Permit No. 3040, 1959 - Newhall Land and Farming Company). [Additional Reference(s): DWR Levee Log, 2002. USACE San Joaquin O&M Manual 601.1, 1967, (HLM 18.91)]. FS Date: 11/1/2018 12:52:00 PM

View of WS. Channel section exposed near waterward toe.

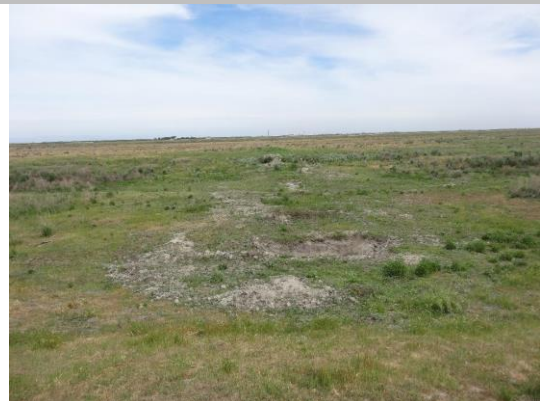
Photo 2 of 3 : UCIP_SP_2019_53191_66564.jpg

Overview of Eastside Bypass.

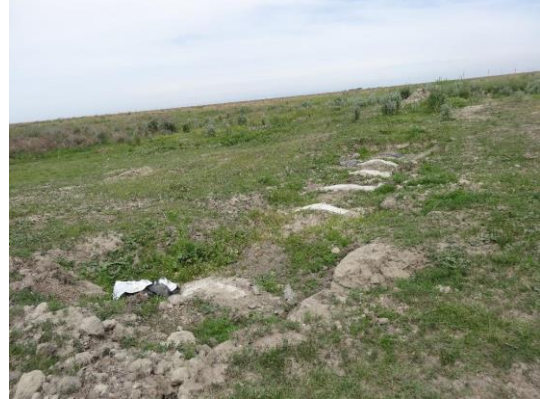
Photo 3 of 3 : UCIP_SP_2019_53191_66563.jpg

Item	DWR UCIP Field Study			37.119268 °	37.119268 °	
				-120.587208 °	-120.587208 °	
DWR ID	19888					
Comment Code						
Inspector Comment						
FS_ID:53191 DS_ID:19888 EP_NO: 3040 Repair Type: Urgent Crossing Status: Found UCIP Comments: 11/01/2018 Signs of pipe leakage (wet spot) visible in floodway. Crossing remains Urgent due to potential leakage along the pipe. Recommend internal inspection to determine pipe integrity through the levee. (O. Magana - DWR UCIP)07/20/2016 Same as previous inspection. Dense vegetation prevents proper inspection along floodway. (DWR UCIP - omagana)04/17/2014 Need to contact owner. Leak on waterward toe approximately 15 feet from toe. Good candidate for video or pressure test. (DWR UCIP - omagana) FIELD_STRUCT_DESC: 48-inch corrugated metal irrigation siphon pipe through the levee, 8.8 feet below the crown. Slide gate in a pipe riser on the landside (LS) slope, not the waterside (WS) slope. Concrete headwall on the LS, not the WS. Siphon extends under the channel. 24-inch corrugated metal cleanout pipe at the center of the channel with a metal plate cover. (Plans for construction of two reinforced concrete siphons across the Eastside Bypass authorized under Permit No. 3040, 1959 - Newhall Land and Farming Company). [Additional Reference(s): DWR Levee Log, 2002. USACE San Joaquin O&M Manual 601.1, 1967, (HLM 18.91)]. FS Date: 11/1/2018 12:52:00 PM

Channel sections have been excavated across Eastside Bypass.

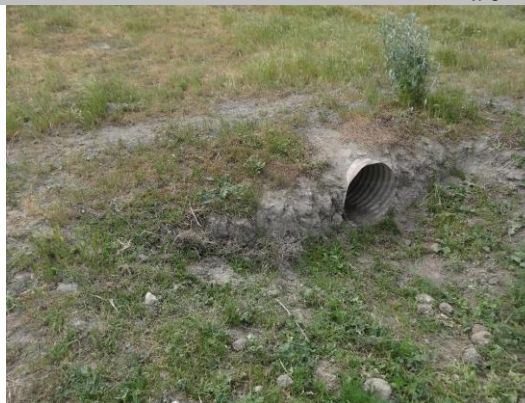
Photo 3 of 3 : UCIP_SP_2019_36687_66581.jpg

Item	DWR UCIP LMA Responsibility			37.118178 °		37.118178 °
				-120.586783 °		-120.586783 °
DWR ID	19889					
Comment Code						
Inspector Comment						
FS_ID:36687						
DS_ID:19889						
EP_NO: N/A						
Repair Type: Non-Urgent						
Crossing Status: Found						
UCIP Comments: 04/17/2014 Dense vegetation limits the inspector's visibility to identify signs of pipe failure (leaks) along the landward slope. Recommend removing vegetation along pipe alignment to conduct proper inspection of structure. (DWR UCIP - O. Magana)						
FIELD_STRUCT_DESC: 24-inch corrugated metal gravity drainage pipe through the levee, 10.2 feet below the crown. Slide gate in a pipe riser on the waterside (WS) slope. [Additional Reference(s): DWR Levee Log, 2002. USACE San Joaquin O&M Manual 601.1, 1967, (HLM 18.97)].						
FS Date: 4/17/2014

Pipe daylight on waterward side.

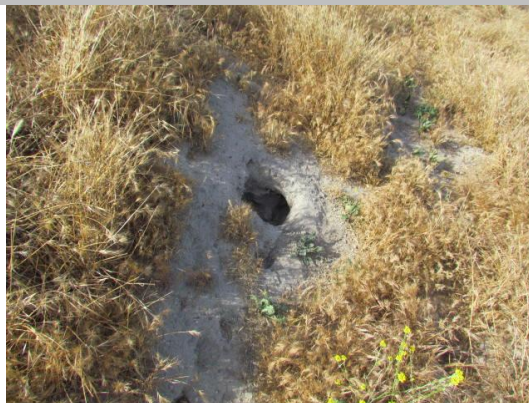
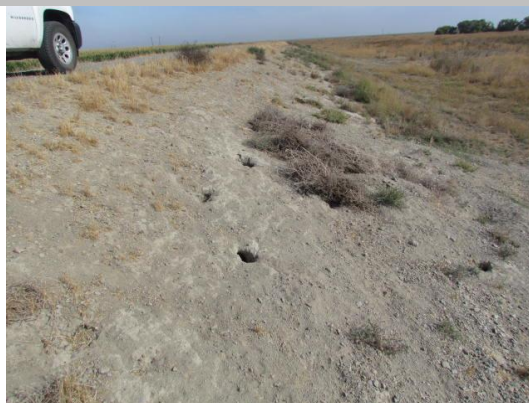
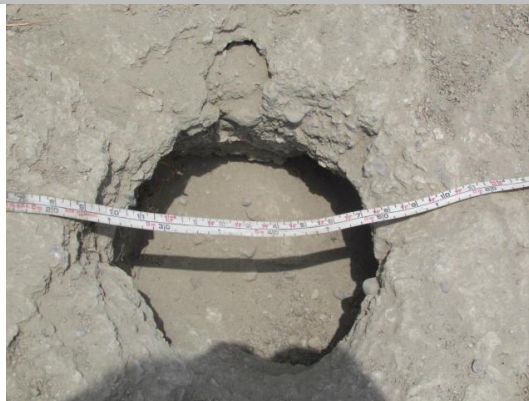
Photo 1 of 5 : SP_2019_NA0010_124_1211_20190307_00053.jpg

LM Start	19.14	Rating **	U	Issue No.	1211
LM End	19.14	Issue Type +	Ma	Location *	WS
Category	Earthen Levee			GPS Latitude/Longitude	
				Start	End
Item	Animal Control			37.114793 °	37.114793 °
				-120.587582 °	-120.587582 °
DWR ID	DWR_NA0010_06_s_2015_1211				
Comment Code					
A1 : Exterminate rodents and backfill and compact or grout burrows.					
Inspector Comment					
Several large rodent holes with more than 2 cubic feet of material were noted on the waterside slope.

Looking at rodent hole on waterward slope. Spring 2016

Looking at several rodent holes on waterward slope. (Fall 2015)

Looking at close-up view of large rodent hole on waterward slope. (Spring 2015)

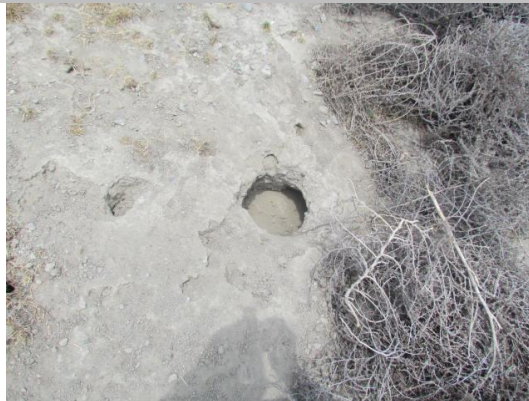
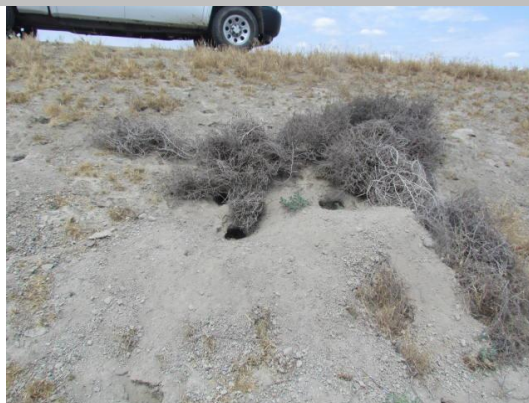
Photo 4 of 5 : SP_2019_NA0010_124_1211_20190307_00056.jpg

LM Start	19.14	Rating **	U	Issue No.	1211 (cont)
LM End	19.14	Issue Type +	Ma	Location *	WS
Category	Earthen Levee			GPS Latitude/Longitude	
				Start	End
Item	Animal Control			37.114793 °	37.114793 °
				-120.587582 °	-120.587582 °
DWR ID	DWR_NA0010_06_s_2015_1211				
Comment Code					
A1 : Exterminate rodents and backfill and compact or grout burrows.					
Inspector Comment					
Several large rodent holes with more than 2 cubic feet of material were noted on the waterside slope.

Looking at large rodent hole on waterward slope. Spring 2015

Looking west at several rodent holes on waterward slope. Spring 2015

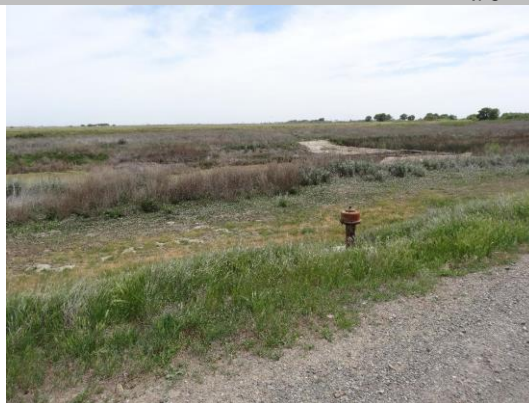
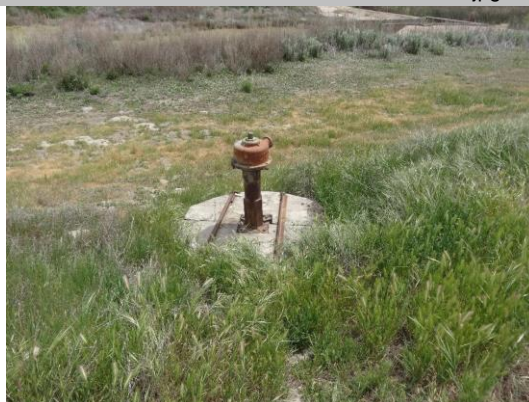
Photo 1 of 3 : UCIP_SP_2019_36688_66583.jpg

Comment Code					
Inspector Comment					
FS_ID:36688 DS_ID:19890 EP_NO: N/A Repair Type: Non-Urgent Crossing Status: Found UCIP Comments: 04/17/2014 Dense vegetation limits the inspector's visibility to identify signs of pipe failure (leaks) along the slopes. Recommend removing vegetation along pipe alignment to conduct proper inspection of structure. (DWR UCIP - O. Magana) FIELD_STRUCT_DESC: 48-inch corrugated metal gravity drainage pipe through the levee, 20 feet below the crown. Slide gate in a pipe riser on the waterside (WS) slope. Riprap along the landside (LS) slope. [Additional Reference(s): DWR Levee Log, 2002. USACE San Joaquin O&M Manual 601.1, 1967, (HLM 19.36)]. FS Date: 4/17/2014

View of waterward side.

Riser located on waterward slope.

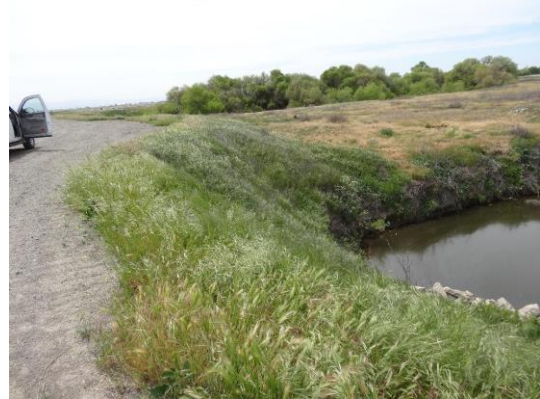
Photo 3 of 3 : UCIP_SP_2019_36688_66586.jpg

Item	DWR UCIP LMA Responsibility			37.112902 °		37.112902 °
				-120.588751 °		-120.588751 °
DWR ID	19890					
Comment Code						
Inspector Comment						
FS_ID:36688 DS_ID:19890 EP_NO: N/A Repair Type: Non-Urgent Crossing Status: Found UCIP Comments: 04/17/2014 Dense vegetation limits the inspector's visibility to identify signs of pipe failure (leaks) along the slopes. Recommend removing vegetation along pipe alignment to conduct proper inspection of structure. (DWR UCIP - O. Magana) FIELD_STRUCT_DESC: 48-inch corrugated metal gravity drainage pipe through the levee, 20 feet below the crown. Slide gate in a pipe riser on the waterside (WS) slope. Riprap along the landside (LS) slope. [Additional Reference(s): DWR Levee Log, 2002. USACE San Joaquin O&M Manual 601.1, 1967, (HLM 19.36)]. FS Date: 4/17/2014

View of landward slope.

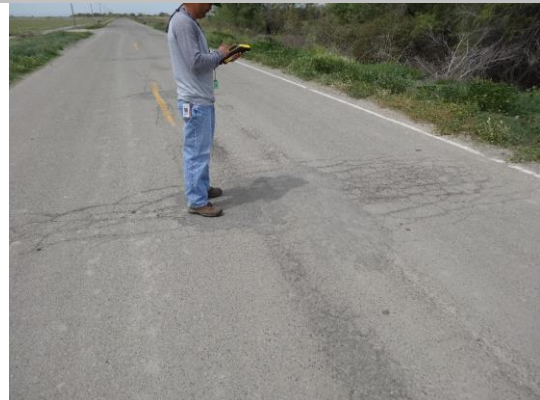
Photo 1 of 3 : UCIP_SP_2019_36689_66591.jpg

Comment Code						
Inspector Comment						
FS_ID:36689						
DS_ID:19891						
EP_NO: N/A						
Repair Type: Non-Urgent						
Crossing Status: Found						
UCIP Comments: 04/17/2014 Dense vegetation limits the inspector's visibility to identify signs of pipe failure (leaks) along the slopes. Recommend removing vegetation along pipe alignment to conduct proper inspection of structure. (DWR UCIP - O. Magana)						
FIELD_STRUCT_DESC: 30-inch by 30-inch reinforced concrete box gravity drainage culvert through the levee, 14 feet below the crown. Flap gate on the waterside (WS) end. [Additional Reference(s): DWR Levee Log, 2002. USACE San Joaquin O&M Manual 601.1, 1967, (HLM 19.85)].						
FS Date: 4/17/2014

Overview of levee crown looking downstream.

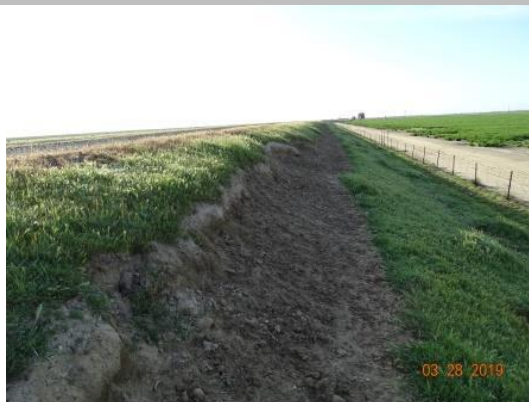
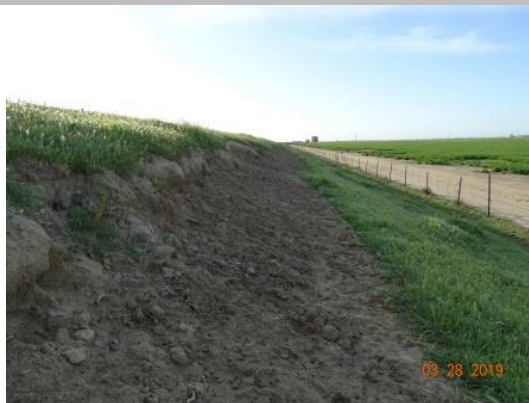
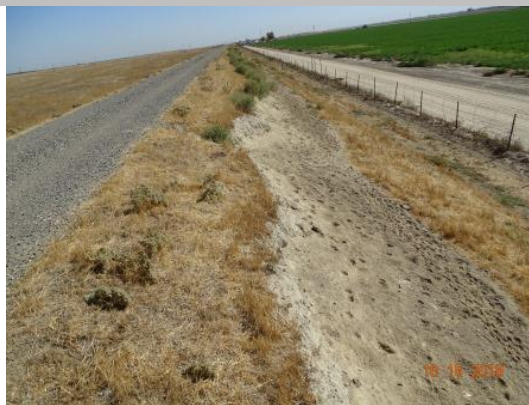
Photo 1 of 3 : SP_2019_NA0010_124_107_20190418_00197.jpg

LM Start	21.71	Rating **	M	Issue No.	107
LM End	21.78	Issue Type +	Ma	Location *	LS
Category	Earthen Levee		GPS Latitude/Longitude		
			Start	End	
Item	Erosion / Bank Caving		37.102844 °	37.102002 °	
			-120.553160 °	-120.552314 °	
DWR ID	DWR_NA0010_06_f_2018_107				
Comment Code					
E1 : Note and monitor erosion site.					
Inspector Comment					
Erosion into levee prism due to livestock activities.

View of erosion in landside levee prism. (Spring 2019)

View of erosion looking upstream. (Spring 2019)

Erosion into levee prism from livestock. (Fall 2018)

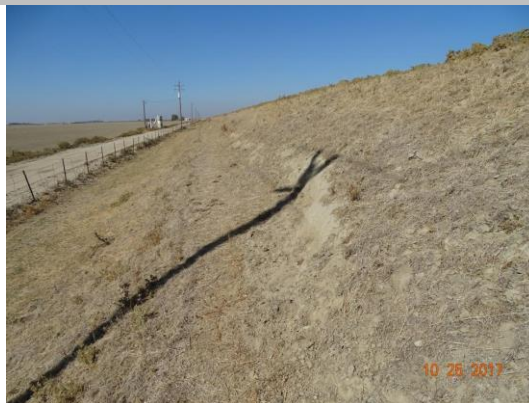
Photo 1 of 1 : SP_2019_NA0010_124_86_20190307_00034.jpg

LM Start	22.41	Rating **	M	Issue No.	86
LM End	22.46	Issue Type +	Ma	Location *	LS
Category	Earthen Levee			GPS Latitude/Longitude	
				Start	End
Item	Slope Stability			37.094969 °	37.094479 °
				-120.544964 °	-120.544435 °
DWR ID	DWR_NA0010_06_f_2017_86				
Comment Code					
S2 : Repair the levee slope damaged by foot traffic and prevent access where possible.					
Inspector Comment					
Erosion greater than 3 inches on landside slope caused by livestock.

Looking northwest at the landside slope.

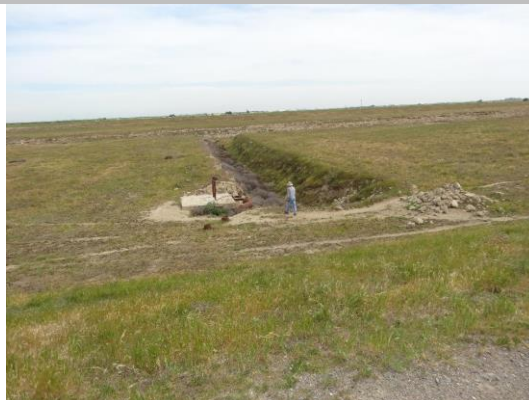
Photo 1 of 3 : UCIP_SP_2019_34010_61871.jpg

Comment Code					
Inspector Comment					
FS_ID:34010 DS_ID:19879 EP_NO: 13638 Repair Type: Non-Urgent Crossing Status: Found UCIP Comments: 04/17/2014 Need to contact owner to determine status. Crossing has been modified. (DWR UCIP - O. Magana) FIELD_STRUCT_DESC: 16-inch coated steel irrigation discharge pipe through the levee, 3.5 feet below the crown. Cutoff wall around the pipe at the center of the levee. Pump on the waterside (WS). Siphon breaker on the landside (LS) shoulder. Intake trench on the WS. (Plans to install a pump with a 16-inch pipeline over the levee authorized under Permit No. 13638, 1983 - Hamonds Ranch). [Additional Reference(s): DWR Levee Log, 2002]. FS Date: 4/17/2014

Overview of levee crown at crossing.

View of waterward side.

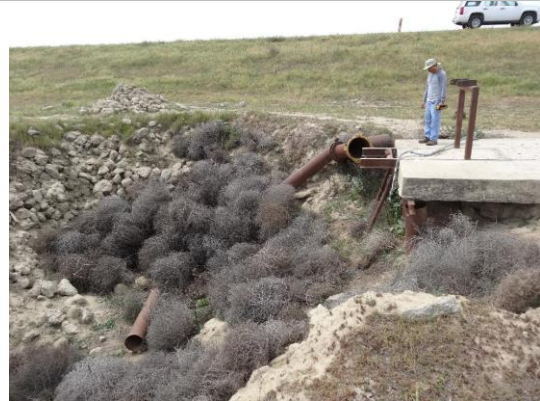
Photo 3 of 3 : UCIP_SP_2019_34010_61875.jpg

Item	DWR UCIP Field Study			37.077406 °	37.077406 °	
				-120.525938 °	-120.525938 °	
DWR ID	19879					
Comment Code						
Inspector Comment						
FS_ID:34010 DS_ID:19879 EP_NO: 13638 Repair Type: Non-Urgent Crossing Status: Found UCIP Comments: 04/17/2014 Need to contact owner to determine status. Crossing has been modified. (DWR UCIP - O. Magana) FIELD_STRUCT_DESC: 16-inch coated steel irrigation discharge pipe through the levee, 3.5 feet below the crown. Cutoff wall around the pipe at the center of the levee. Pump on the waterside (WS). Siphon breaker on the landside (LS) shoulder. Intake trench on the WS. (Plans to install a pump with a 16-inch pipeline over the levee authorized under Permit No. 13638, 1983 - Hamonds Ranch). [Additional Reference(s): DWR Levee Log, 2002]. FS Date: 4/17/2014

Concrete pad with abandoned support frame located on waterward side.

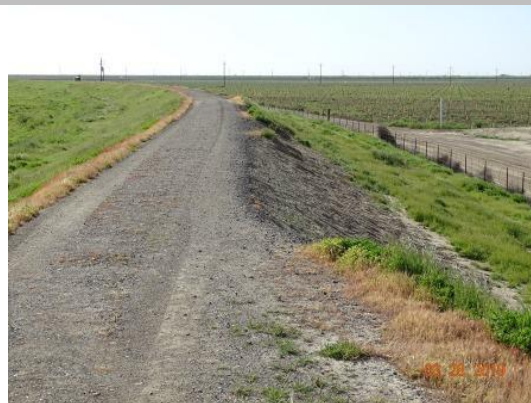
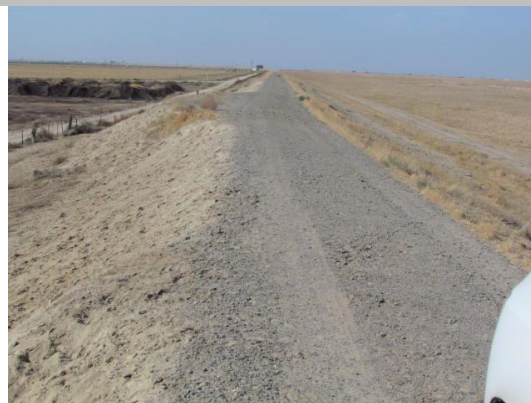
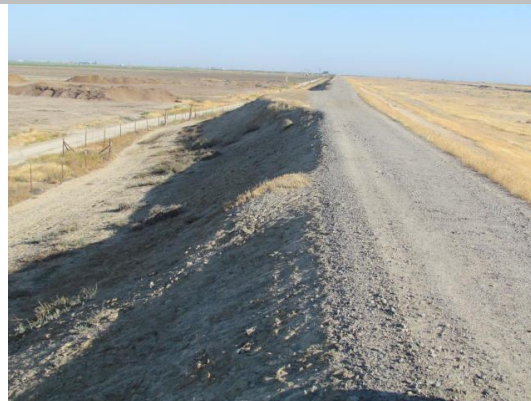
Photo 1 of 3 : SP_2019_NA0010_124_3_20190418_00199.jpg

LM Start	27.43	Rating **	M	Issue No.	3
LM End	27.97	Issue Type +	Ma	Location *	LS
Category	Earthen Levee			GPS Latitude/Longitude	
				Start	End
Item	Slope Stability			37.036955 °	37.032887 °
				-120.484395 °	-120.481225 °
DWR ID	DWR_NA0010_06_s_2012_3				
Comment Code					
S2 : Repair the levee slope damaged by foot traffic and prevent access where possible.					
Inspector Comment					
Landside erosion caused by livestock. Erosion greater than 3" in depth on landside slope. Levee crown has narrowed within this reach.

Looking south along landside slope. (Spring 2019)

Looking north at livestock erosion on landward slope. Fall 2015

Looking north at livestock erosion on landward slope. (Spring 2013)

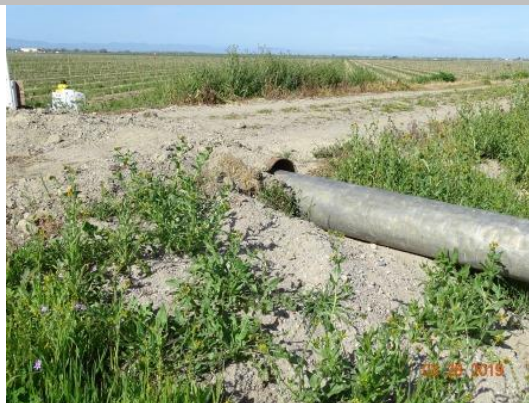
Photo 1 of 2 : SP_2019_NA0010_124_127_20190418_00200.jpg

LM Start	28.18	Rating **	U	Issue No.	127
LM End	28.18	Issue Type +	En	Location *	CR
Category	Earthen Levee			GPS Latitude/Longitude	
				Start	End
Item	Encroachments			37.030924 °	37.030924 °
				-120.478411 °	-120.478411 °
DWR ID	DWR_NA0010_06_s _ 2019_127				
Comment Code					
PI : Pipe					
Inspector Comment					
Landowner has installed pipe in levee crown.

View of pipe crossing looking southeast. (Spring 2019)

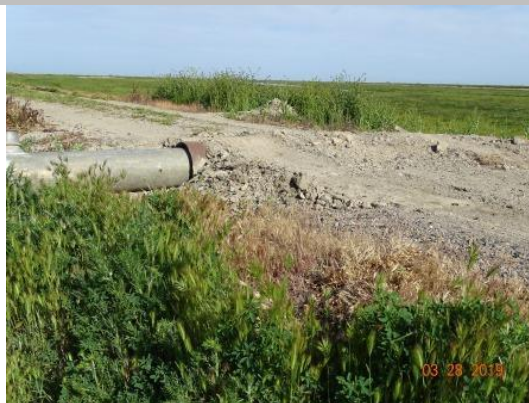
Photo 2 of 2 : SP_2019_NA0010_124_127_20190418_00202.jpg

LM Start	28.18	Rating **	U	Issue No.	127 (cont)
LM End	28.18	Issue Type +	En	Location *	CR
Category	Earthen Levee			GPS Latitude/Longitude	
				Start	End
Item	Encroachments			37.030924 °	37.030924 °
				-120.478411 °	-120.478411 °
DWR ID	DWR_NA0010_06_s_2019_127				
Comment Code					
PI : Pipe					
Inspector Comment					
Landowner has installed pipe in levee crown.

View of pipe crossing looking south. (spring 2019)

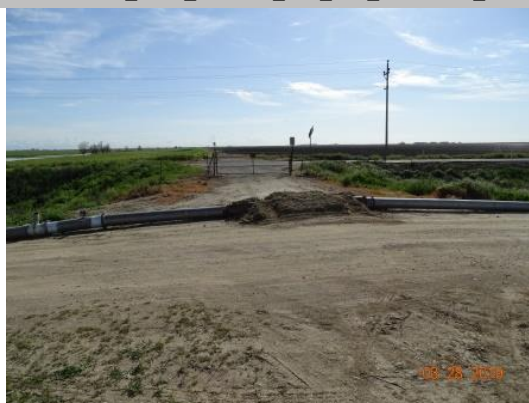
Photo 1 of 3 : SP_2019_NA0010_124_110_20190418_00203.jpg

LM Start	28.43	Rating **	U	Issue No.	110
LM End	28.43	Issue Type +	En	Location *	CR
Category	Earthen Levee			GPS Latitude/Longitude	
				Start	End
Item	Encroachments			37.029935 °	37.029935 °
				-120.474057 °	-120.474057 °
DWR ID	DWR_NA0010_06_s_2019_110				
Comment Code					
PI : Pipe					
Inspector Comment					
Landowner has installed a temporary pipe across the levee. The size of the pipe and short ramp increases the chances of vehicles bottoming out.

View of temporary pipe looking upstream. (Spring 2019)

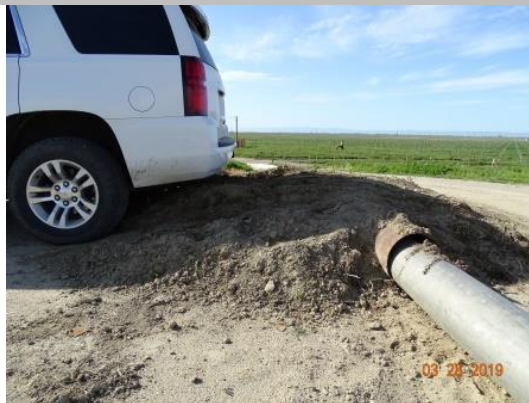
Photo 2 of 3 : SP_2019_NA0010_124_110_20190418_00205.jpg

View of pipe crossing looking West. (Spring 2019)

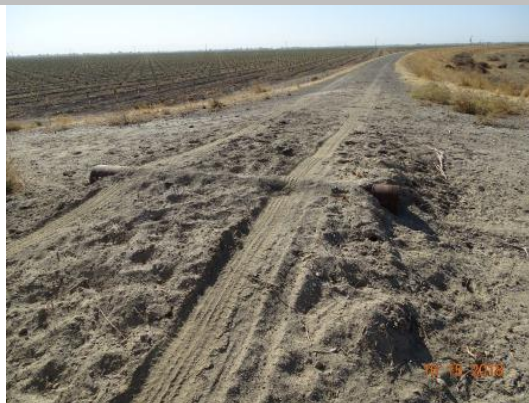
Photo 3 of 3 : SP_2019_NA0010_124_110_20190307_00047.jpg

LM Start	28.43	Rating **	U	Issue No.	110 (cont)	
LM End	28.43	Issue Type +	En	Location *	CR	
Category	Earthen Levee			GPS Latitude/Longitude		
				Start		End
Item	Encroachments			37.029935 °		37.029935 °
				-120.474057 °		-120.474057 °
DWR ID	DWR_NA0010_06_s _ 2019_110					
Comment Code						
PI : Pipe						
Inspector Comment						
Landowner has installed a temporary pipe across the levee. The size of the pipe and short ramp increases the chances of vehicles bottoming out.

Landowner has installed a temporary pipe across levee crown. (Fall 2018)

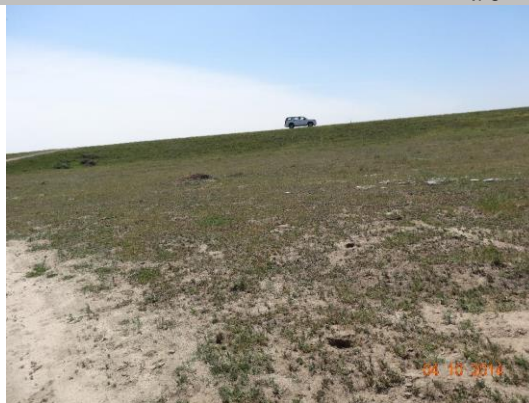
Photo 1 of 3 : UCIP_SP_2019_36693_66607.jpg

Comment Code					
Inspector Comment					
FS_ID:36693 DS_ID:19882 EP_NO: N/A Repair Type: Non-Urgent Crossing Status: Found UCIP Comments: 04/10/2014 Altered crossing--steel pipe section on landward side and concrete pipe section on waterward side. Joints on waterward side seperated. Need to contact owner to determine status. (DWR UCIP - O. Magana) FIELD_STRUCT_DESC: [Rodunder Siphon Structure] 48-inch reinforced concrete irrigation siphon pipe through the levee, 14.5 feet below the crown. Concrete U-shaped headwall on the outlet structure on the landside (LS) end. Slide gate mounted on the headwall. [Additional Reference(s): DWR Levee Log, 2002. USACE San Joaquin O&M Manual 601.1, 1967, (HLM 30.27)]. FS Date: 4/10/2014

Overview of waterward side.

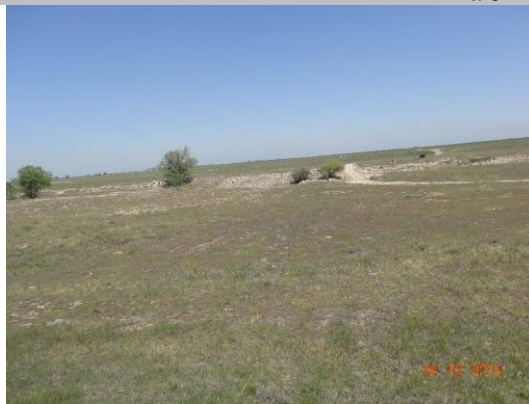
Photo 2 of 3 : UCIP_SP_2019_36693_66604.jpg

Overview of Eastside Bypass at crossing.

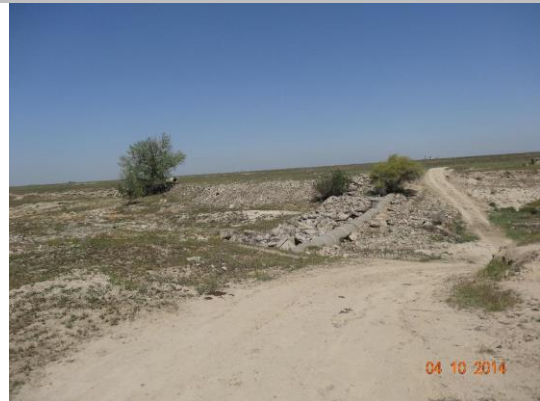
Photo 3 of 3 : UCIP_SP_2019_36693_66609.jpg

Item	DWR UCIP Field Study			37.027330 °	37.027330 °	
				-120.441498 °	-120.441498 °	
DWR ID	19882					
Comment Code						
Inspector Comment						
FS_ID:36693 DS_ID:19882 EP_NO: N/A Repair Type: Non-Urgent Crossing Status: Found UCIP Comments: 04/10/2014 Altered crossing--steel pipe section on landward side and concrete pipe section on waterward side. Joints on waterward side seperated. Need to contact owner to determine status. (DWR UCIP - O. Magana) FIELD_STRUCT_DESC: [Rodunder Siphon Structure] 48-inch reinforced concrete irrigation siphon pipe through the levee, 14.5 feet below the crown. Concrete U-shaped headwall on the outlet structure on the landside (LS) end. Slide gate mounted on the headwall. [Additional Reference(s): DWR Levee Log, 2002. USACE San Joaquin O&M Manual 601.1, 1967, (HLM 30.27)]. FS Date: 4/10/2014

Concrete pipe through Eastside Bypass exposed.

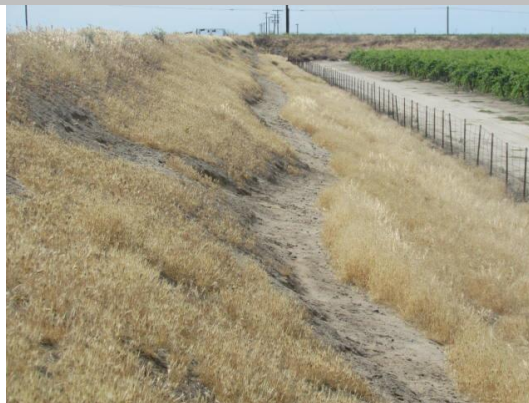
Photo 2 of 2 : SP_2019_NA0010_124_1207_20190307_00049.jpg

LM Start	30.81	Rating **	M	Issue No.	1207 (cont)	
LM End	31.06	Issue Type +	Ma	Location *	LS	
Category	Earthen Levee			GPS Latitude/Longitude		
				Start		End
Item	Erosion / Bank Caving			37.021615 °		37.018428 °
				-120.437587 °		-120.435378 °
DWR ID	DWR_NA0010_06_s _ 2015_1207					
Comment Code						
E1 : Note and monitor erosion site.						
Inspector Comment						
Landside erosion greater than 1" in depth and greater than 3" in length. Erosion is caused by livestock traffic.

Looking south at livestock erosion on landward slope.

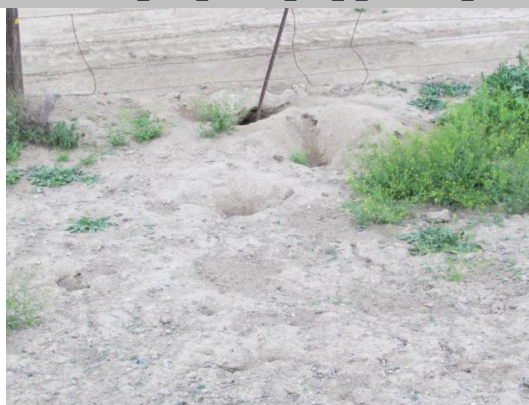
Photo 1 of 2 : SP_2019_NA0010_124_2_20190307_00001.jpg

LM Start	31.10	Rating **	U	Issue No.	2
LM End	31.10	Issue Type +	Ma	Location *	LS
Category	Earthen Levee			GPS Latitude/Longitude	
				Start	End
Item	Animal Control			37.017955 °	37.017955 °
				-120.435017 °	-120.435017 °
DWR ID	DWR_NA0010_06_s _ 2012_2				
Comment Code					
A1 : Exterminate rodents and backfill and compact or grout burrows.					
Inspector Comment

Looking west at rodent holes on landside slope and toe near fence line.

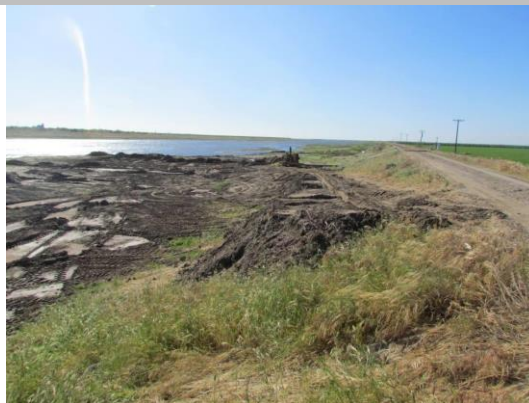
Photo 1 of 1 : SP_2019_NA0010_124_80_20190307_00028.jpg

LM Start	31.10	Rating **	U	Issue No.	80
LM End	31.10	Issue Type +	En	Location *	WS
Category	Earthen Levee			GPS Latitude/Longitude	
				Start	End
Item	Encroachments			37.017907 °	37.017907 °
				-120.434970 °	-120.434970 °
DWR ID	DWR_NA0010_06_s_2017_80				
Comment Code					
RA : Ramp					
Inspector Comment					
Farmer installed ramp on waterside slope.

Looking upstream at ramp on waterward slope.

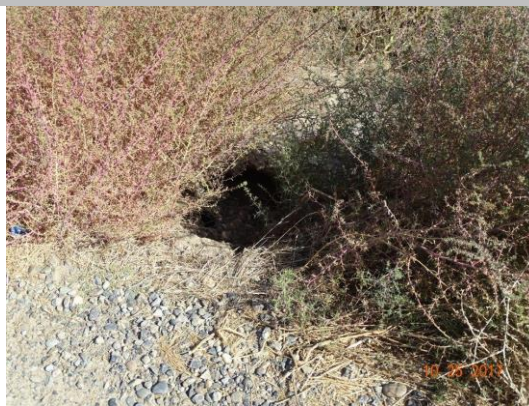
Photo 1 of 1 : SP_2019_NA0010_124_82_20190307_00030.jpg

LM Start	31.14	Rating **	U	Issue No.	82
LM End	31.14	Issue Type +	Ma	Location *	WS
Category	Earthen Levee			GPS Latitude/Longitude	
				Start	End
Item	Animal Control			37.017445 °	37.017445 °
				-120.434713 °	-120.434713 °
DWR ID	DWR_NA0010_06_f_2017_82				
Comment Code					
A3 : No rodents visible, but rodent burrows visible; need to backfill and compact or grout burrows.					
Inspector Comment

Looking east at the waterside slope.

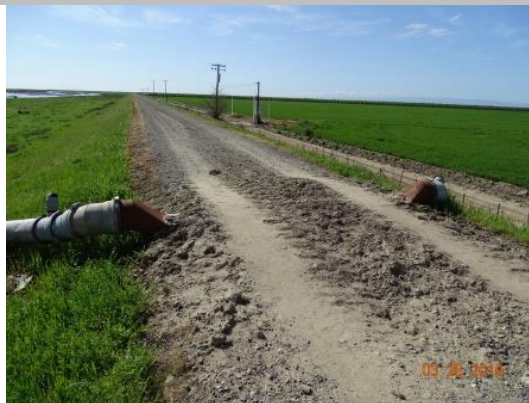
Photo 1 of 1 : SP_2019_NA0010_124_128_20190418_00206.jpg

LM Start	31.18	Rating **	M	Issue No.	128
LM End	31.18	Issue Type +	En	Location *	CR
Category	Earthen Levee			GPS Latitude/Longitude	
				Start	End
Item	Encroachments			37.016932 °	37.016932 °
				-120.434346 °	-120.434346 °
DWR ID	DWR_NA0010_06_s_2019_128				
Comment Code					
PI : Pipe					
Inspector Comment					
Temporary pipe is installed across levee crown by landowner.

View of pipe crossing looking upstream. (Spring 2019)

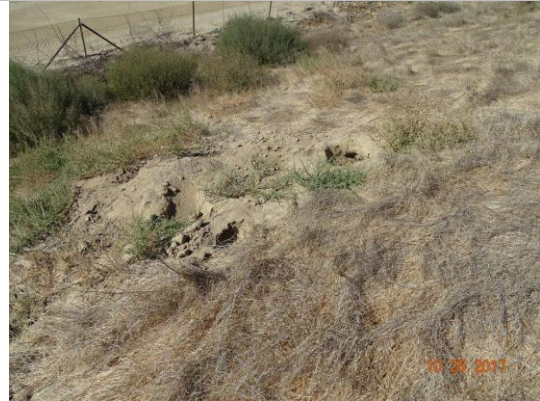
Photo 1 of 1 : SP_2019_NA0010_124_81_20190307_00029.jpg

LM Start	32.00	Rating **	U	Issue No.	81
LM End	32.00	Issue Type +	Ma	Location *	LS
Category	Earthen Levee			GPS Latitude/Longitude	
				Start	End
Item	Animal Control			37.007007 °	37.007007 °
				-120.426179 °	-120.426179 °
DWR ID	DWR_NA0010_06_f _ 2017_81				
Comment Code					
A3 : No rodents visible, but rodent burrows visible; need to backfill and compact or grout burrows.					
Inspector Comment

Looking west at the landside slope.

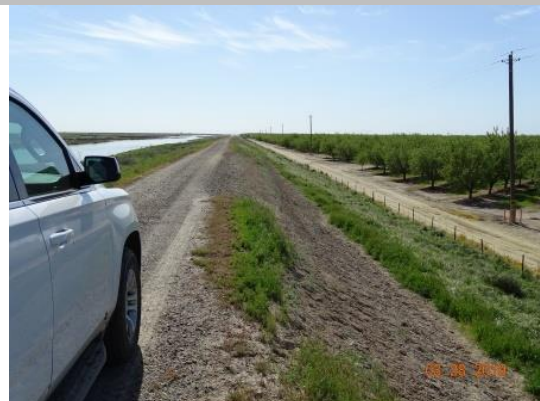
Photo 1 of 1 : SP_2019_NA0010_124_129_20190418_00207.jpg

LM Start	32.62	Rating **	M	Issue No.	129
LM End	32.87	Issue Type +	Ma	Location *	LS
Category	Earthen Levee			GPS Latitude/Longitude	
				Start	End
Item	Slope Stability			37.000645 °	36.997930 °
				-120.418415 °	-120.415406 °
DWR ID	DWR_NA0010_06_s_2019_129				
Comment Code					
S2 : Repair the levee slope damaged by foot traffic and prevent access where possible.					
Inspector Comment					
Slope damage from livestock. Damage is beginning to erode into levee crown.

Erosion from animal activity along the landside slope. (Spring 2019)

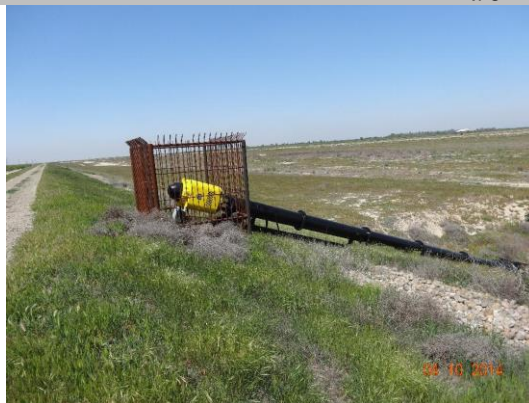
Photo 1 of 3 : UCIP_SP_2019_46183_61898.jpg

Comment Code					
Inspector Comment					
FS_ID:46183 DS_ID:19883 EP_NO: 6416A Repair Type: Non-Urgent Crossing Status: Found UCIP Comments: 04/10/2014 Crossing updated--need to contact owner to determine permit issued by CVFPB for authorized changes. (DWR UCIP - O. Magana) FIELD_STRUCT_DESC: 20-inch (not 18 inch as mentioned in the DS study) coated steel drainage discharge pipe through the levee, 3.9 feet below the crown. Electrical conduit through the levee. Cutoff wall around pipe at centerline of levee. Capped with a welded plate on the landside (LS) end. Siphon breaker on the apex of the pipe on the LS shoulder. Slant pump on the waterside (WS) slope. (To revise plans for a slant pump and an 18-inch steel pipe through the levee authorized under Permit No. 6416-A, 1975 - Triangle T. Ranch, Inc.). [Additional Reference(s): DWR Levee Log, 2002]. FS Date: 4/10/2014

View of waterward side--pipe and pump fenced off on waterward slope.

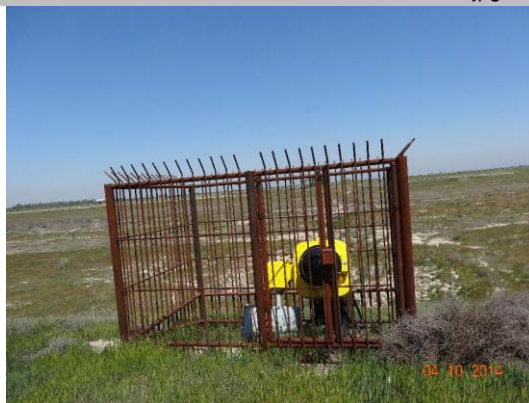
Photo 2 of 3 : UCIP_SP_2019_46183_61902.jpg

Electrical conduit visible on waterward slope.

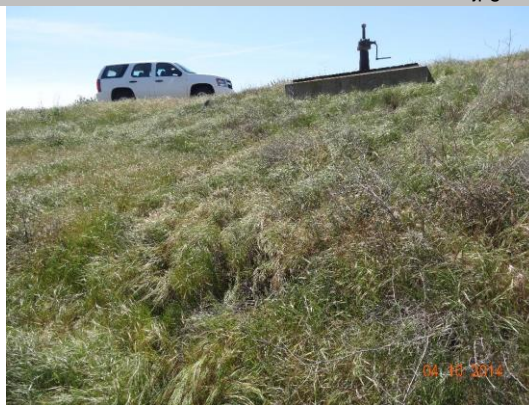
Photo 2 of 3 : UCIP_SP_2019_39481_66632.jpg

View of waterward slope covered by dense vegetation.

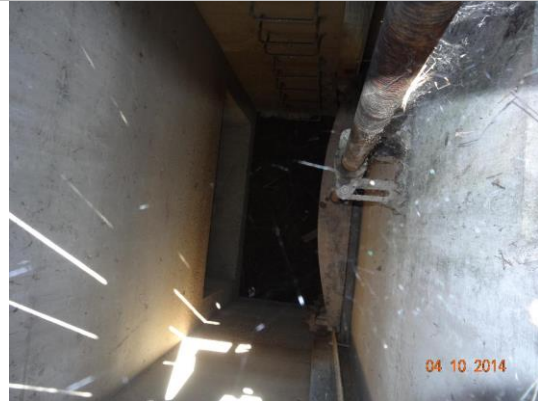
Photo 3 of 3 : UCIP_SP_2019_39481_66629.jpg

Comment Code					
Inspector Comment					
FS_ID:39481 DS_ID:19813 EP_NO: N/A Repair Type: Non-Urgent Crossing Status: Found UCIP Comments: 04/10/2014 Dense vegetation limits the inspector's visibility to identify signs of pipe failure (leaks) along the slope. Recommend removing vegetation along pipe alignment to conduct proper inspection of structure and appurtenances. High vegetation along crossing alignment--recommend removing vegetation along pipe crossing. (DWR UCIP - O. Magana) FIELD_STRUCT_DESC: [Fresno River Irrigation Structure] 48-inch by 72-inch reinforced concrete box gravity irrigation culvert through the levee, 15.1 feet below the crown. Slide gate in a concrete riser in the waterside (WS) slope. Concrete U-shaped headwall on each end. Landside (LS) channel cobble revetted for 8 feet. [Additional Reference(s): DWR Levee Log, 2002. USACE San Joaquin O&M Manual 601.1, 1967, (HLM 35.33)]. FS Date: 4/10/2014

Inside view of concrete box located on waterward slope.

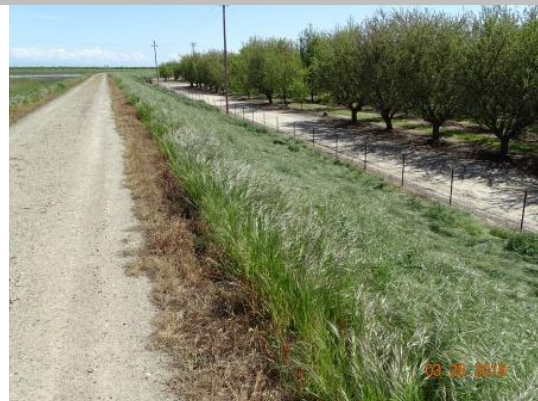
Photo 1 of 1 : SP_2019_NA0010_124_131_20190418_00208.jpg

LM Start	35.83	Rating **	U	Issue No.	131
LM End	36.46	Issue Type +	Ma	Location *	LS
Category	Earthen Levee			GPS Latitude/Longitude	
				Start	End
Item	Vegetation			36.974391 °	36.974226 °
				-120.374734 °	-120.363405 °
DWR ID	DWR_NA0010_06_s_2019_131				
Comment Code					
V1 : Control annual grass and weeds on the levee slopes and easements.					
Inspector Comment

View of vegetation along landside slope. (Spring 2019)

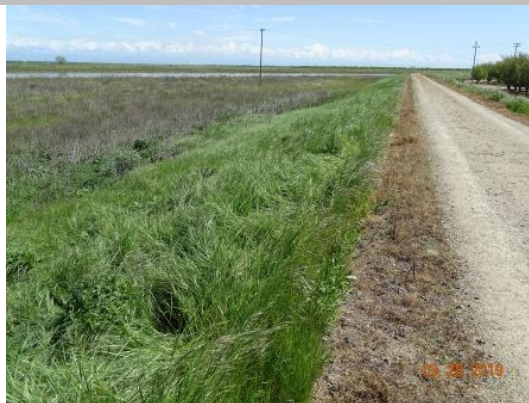
Photo 1 of 1 : SP_2019_NA0010_124_132_20190418_00209.jpg

LM Start	35.83	Rating **	U	Issue No.	132
LM End	36.46	Issue Type +	Ma	Location *	WS
Category	Earthen Levee			GPS Latitude/Longitude	
				Start	End
Item	Vegetation			36.974391 °	36.974225 °
				-120.374734 °	-120.363404 °
DWR ID	DWR_NA0010_06_s_2019_132				
Comment Code					
V1 : Control annual grass and weeds on the levee slopes and easements.					
Inspector Comment

Vegetation along waterside slope looking upstream. (Spring 2019)

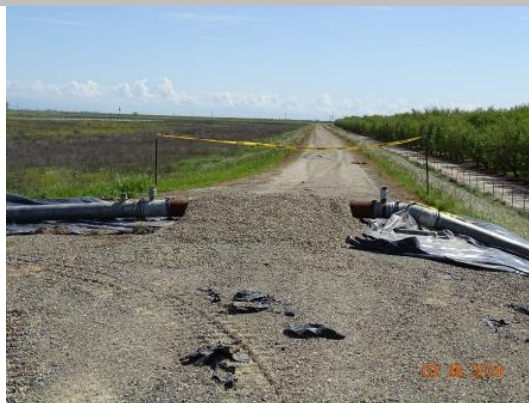
Photo 1 of 2 : SP_2019_NA0010_124_130_20190418_00210.jpg

LM Start	35.84	Rating **	U	Issue No.	130
LM End	35.84	Issue Type +	En	Location *	CR
Category	Earthen Levee			GPS Latitude/Longitude	
				Start	End
Item	Encroachments			36.974417 °	36.974417 °
				-120.374479 °	-120.374479 °
DWR ID	DWR_NA0010_06_s_2019_130				
Comment Code					
PI : Pipe					
Inspector Comment					
Landowner has installed a pipe across the levee crown.

View of pipe across levee crown looking upstream. (Spring 2019)

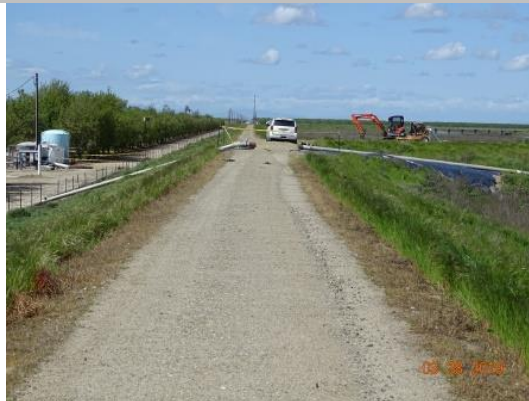
Photo 2 of 2 : SP_2019_NA0010_124_130_20190418_00211.jpg

LM Start	35.84	Rating **	U	Issue No.	130 (cont)
LM End	35.84	Issue Type +	En	Location *	CR

View of pipe crossing looking downstream. (Spring 2019)

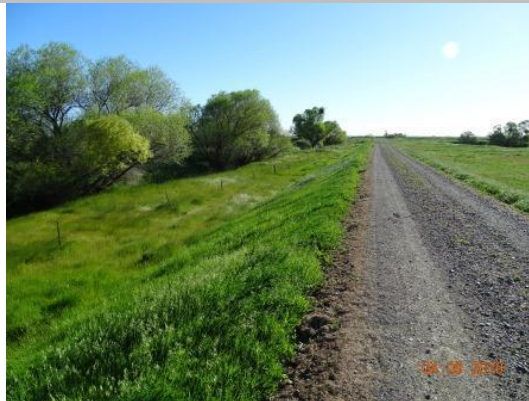
Photo 1 of 1 : SP_2019_NA0010_125_22_20190423_00047.jpg

LM Start	0.01	Rating **	M	Issue No.	22
LM End	1.17	Issue Type +	Ma	Location *	WS
Category	Earthen Levee			GPS Latitude/Longitude	
				Start	End
Item	Vegetation			37.255614 °	37.264431 °
				-120.772242 °	-120.756672 °
DWR ID	DWR_NA0010_07_s_2019_22				
Comment Code					
V1 : Control annual grass and weeds on the levee slopes and easements.					
Inspector Comment

View of waterside slope looking downstream. (Spring 2019)

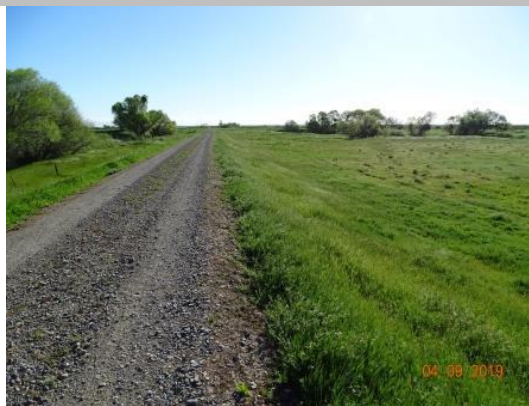
Photo 1 of 1 : SP_2019_NA0010_125_17_20190423_00048.jpg

LM Start	0.01	Rating **	M	Issue No.	17
LM End	1.42	Issue Type +	Ma	Location *	LS
Category	Earthen Levee			GPS Latitude/Longitude	
				Start	End
Item	Vegetation			37.255615 °	37.264277 °
				-120.772242 °	-120.752093 °
DWR ID	DWR_NA0010_07_s_2019_17				
Comment Code					
V1 : Control annual grass and weeds on the levee slopes and easements.					
Inspector Comment

View of landside slope looking downstream. (Spring 2019)

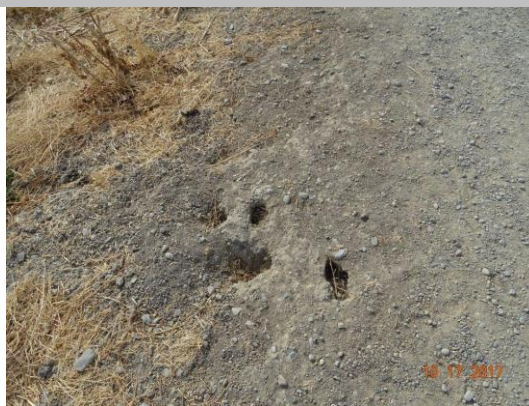
Photo 1 of 2 : SP_2019_NA0010_125_29_20190307_00012.jpg

LM Start	0.24	Rating **	M	Issue No.	29
LM End	0.50	Issue Type +	Ma	Location *	LS
Category	Earthen Levee			GPS Latitude/Longitude	
				Start	End
Item	Animal Control			37.256936 °	37.258722 °
				-120.768472 °	-120.764867 °
DWR ID	DWR_NA0010_07_s_2012_29				
Comment Code					
A3 : No rodents visible, but rodent burrows visible; need to backfill and compact or grout burrows.					
Inspector Comment					
Several rodent holes were noted on the landside and waterside slope and shoulder.

Looking north at landside slope.

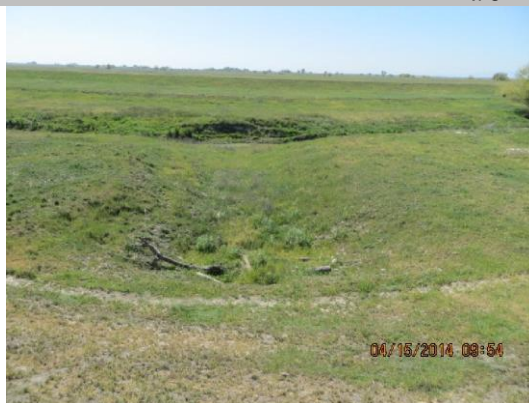
Photo 1 of 3 : UCIP_SP_2019_33712_60958.jpg

LM Start	0.33	Rating **	A/W	Issue No.	31
LM End	0.33	Issue Type +	Ma	Location *	
Category	Supplemental			GPS Latitude/Longitude	
				Start	End
Item	DWR UCIP LMA Responsibility			37.257691 °	37.257691 °
				-120.767203 °	-120.767203 °
DWR ID	19893				
Comment Code					
Inspector Comment					
FS_ID:33712					
DS_ID:19893					
EP_NO: N/A					
Repair Type: No Action Needed					
Crossing Status: Found					
UCIP Comments:					
FIELD_STRUCT_DESC: 24-inch corrugated metal gravity drainage pipe through the levee, 11.1 feet below the crown. Flap gate on the waterside (WS) end. Concrete headwall on the landside (LS) end. Concrete U-shaped headwall on the WS end. [Additional Reference(s): DWR Levee Log, 2002. USACE San Joaquin O&M Manual 601.1, 1967, (HLM 0.33)].					
FS Date: 4/15/2014

Pipe and headwall on WS toe.

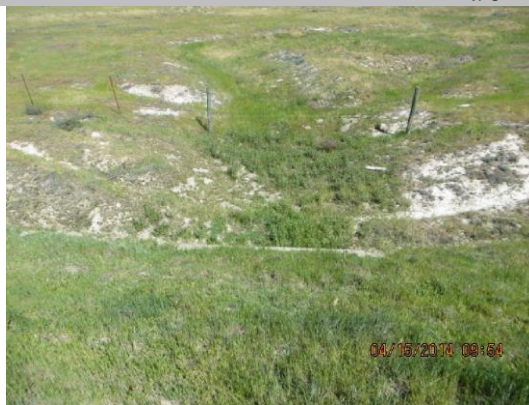
Photo 3 of 3 : UCIP_SP_2019_33712_60959.jpg

LM Start	0.33	Rating **	A/W	Issue No.	31 (cont)
LM End	0.33	Issue Type +	Ma	Location *

Pipe and headwall on LS toe.

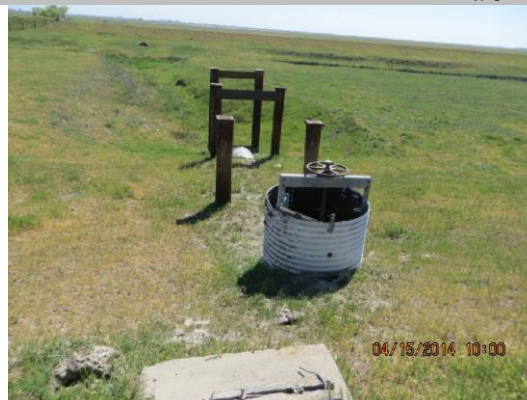
Photo 1 of 3 : UCIP_SP_2019_33713_60963.jpg

Comment Code					
Inspector Comment					
FS_ID:33713 DS_ID:19894 EP_NO: N/A Repair Type: Non-Urgent Crossing Status: Found UCIP Comments: 04/15/2014 Slide gate not operable, but left in closed position. Need to reinstall covers over slide gate standpipe. (DWR UCIP - W. Wylie) FIELD_STRUCT_DESC: 36-inch corrugated metal gravity drainage pipe through the levee, 9.7 feet below the crown. Slide gate in a 48-inch corrugated metal pipe (CMP) riser on the landside (LS) slope. Concrete U-shaped headwall on the LS end. Inlet channel cobble revetted. Dilapidated wooden pier on the waterside (WS). WS slope and outlet ditch cobble revetted. [Additional Reference(s): DWR Levee Log, 2002. USACE San Joaquin O&M Manual 601.1, 1967, (HLM 0.49)]. FS Date: 4/15/2014

LM Start	0.49	Rating **	M	Issue No.	32 (cont)
LM End	0.49	Issue Type +	Ma	Location *

Slide gate in CMP riser on WS slope.

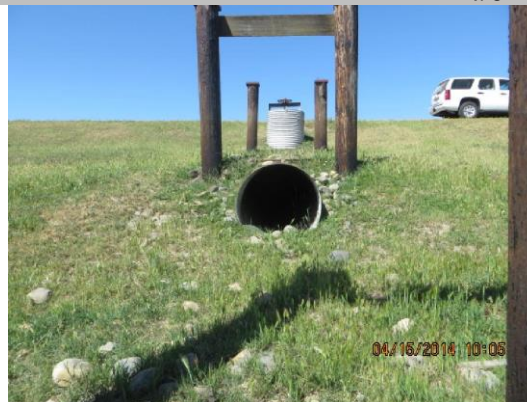
Photo 2 of 3 : UCIP_SP_2019_33713_60965.jpg

Outlet on WS slope.

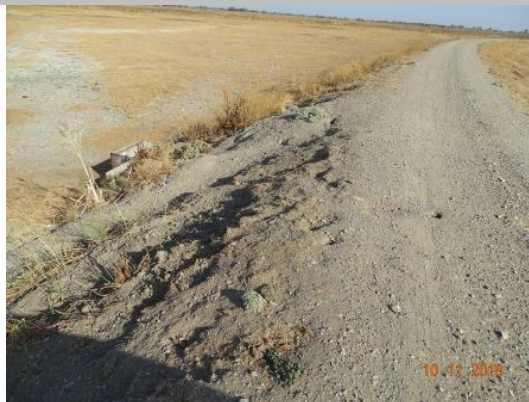
Photo 1 of 2 : SP_2019_NA0010_125_18_20190307_00008.jpg

LM Start	0.53	Rating **	M	Issue No.	18
LM End	0.53	Issue Type +	Ma	Location *	LS
Category	Earthen Levee			GPS Latitude/Longitude	
				Start	End
Item	Slope Stability			37.259097 °	37.259097 °
				-120.764846 °	-120.764846 °
DWR ID	DWR_NA0010_07_f_2018_18				
Comment Code					
S2 : Repair the levee slope damaged by foot traffic and prevent access where possible.					
Inspector Comment					
There is livestock damage to the landside slope.

View of damage from livestock looking upstream. (Fall 2018)

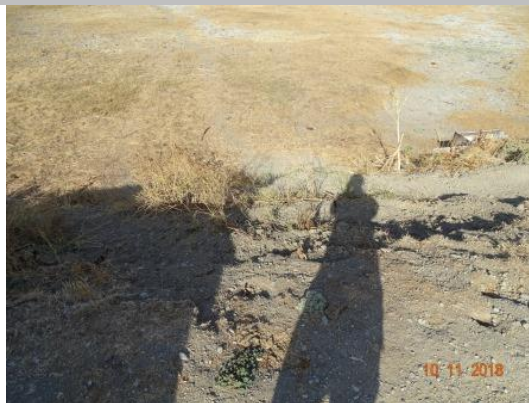
Photo 2 of 2 : SP_2019_NA0010_125_18_20190307_00009.jpg

LM Start	0.53	Rating **	M	Issue No.	18 (cont)	
LM End	0.53	Issue Type +	Ma	Location *	LS	
Category	Earthen Levee			GPS Latitude/Longitude		
				Start		End
Item	Slope Stability			37.259097 °		37.259097 °
				-120.764846 °		-120.764846 °
DWR ID	DWR_NA0010_07_f_2018_18					
Comment Code						
S2 : Repair the levee slope damaged by foot traffic and prevent access where possible.						
Inspector Comment						
There is livestock damage to the landside slope.

View of damage looking down landside slope. (2018)

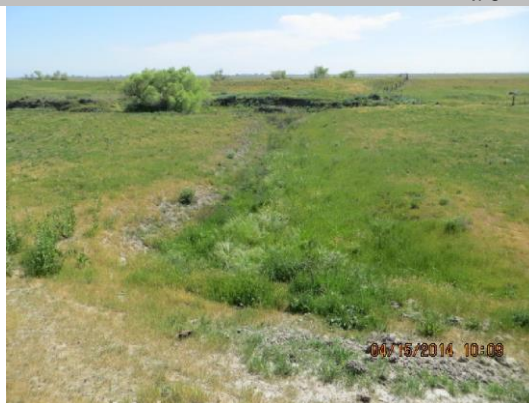
Photo 1 of 3 : UCIP_SP_2019_33723_60981.jpg

LM Start	0.53	Rating **	A/W	Issue No.	33
LM End	0.53	Issue Type +	Ma	Location *	
Category	Supplemental			GPS Latitude/Longitude	
				Start	End
Item	DWR UCIP LMA Responsibility			37.259163 °	37.259163 °
				-120.764860 °	-120.764860 °
DWR ID	19895				
Comment Code					
Inspector Comment					
FS_ID:33723 DS_ID:19895 EP_NO: N/A Repair Type: No Action Needed Crossing Status: Found UCIP Comments: FIELD_STRUCT_DESC: 24-inch corrugated metal gravity drainage pipe through the levee, 9 feet below the crown. Flap gate on the waterside (WS) end. Concrete headwall with a wooden weir at the inlet on the landside (LS) toe. Concrete U-shaped headwall on the WS toe. [Additional Reference(s): DWR Levee Log, 2002. USACE San Joaquin O&M Manual 601.1, 1967, (HLM 0.53)]. FS Date: 4/15/2014

Headwall and flapgate on WS toe.

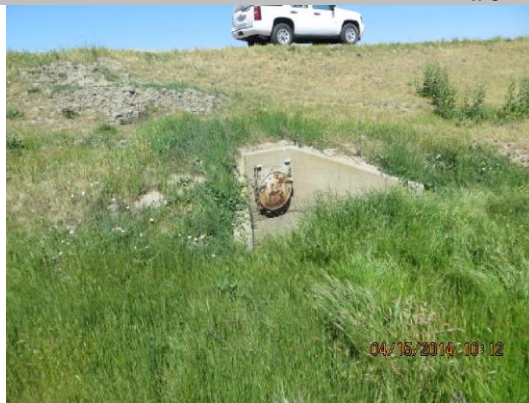
Photo 2 of 3 : UCIP_SP_2019_33723_60983.jpg

LM Start	0.53	Rating **	A/W	Issue No.	33 (cont)
LM End	0.53	Issue Type +	Ma	Location *

Flapgate on concrete headwall at WS toe.

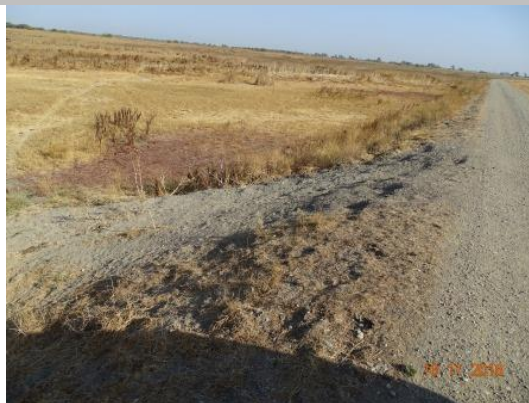
Photo 1 of 1 : SP_2019_NA0010_125_19_20190307_00010.jpg

LM Start	0.70	Rating **	M	Issue No.	19
LM End	0.70	Issue Type +	Ma	Location *	LS
Category	Earthen Levee			GPS Latitude/Longitude	
				Start	End
Item	Slope Stability			37.261337 °	37.261337 °
				-120.763303 °	-120.763303 °
DWR ID	DWR_NA0010_07_f_2018_19				
Comment Code					
S2 : Repair the levee slope damaged by foot traffic and prevent access where possible.					
Inspector Comment					
There is livestock damage to the landside slope.

Damage to landside slope from livestock. (Fall 2018)
