**Flood Control Project Maintenance
Levee Inspections**
LMA District Cover Sheet
Spring 2019 Levee Inspection Results

Lower San Joaquin Levee District

Spring 2019 Levee Inspection Results

Waterway			Bank	Unit Miles
Unit No. 01 San Joaquin River			Right	22.52
	Spring (March - May)	Summer (June - August)	(September - November) Fall	Winter (December - February)
Unit Maintenance Rating (Fall Only)				
Date of Inspection	3/26/2019 - 3/26/2019			
DWR Inspector	Corey Fujitani			
Accompanied By

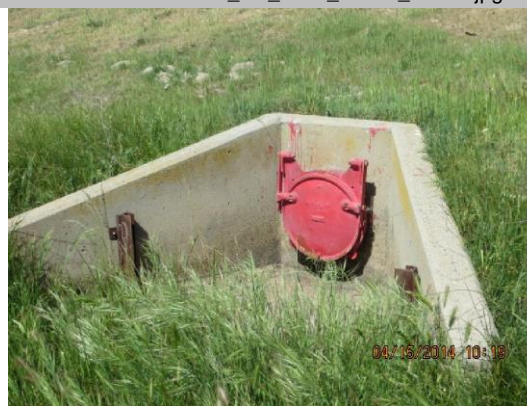
Photo 2 of 3 : UCIP_SP_2019_39507_60988.jpg

Comment Code						
Inspector Comment						
FS_ID:39507						
DS_ID:19896						
EP_NO: N/A						
Repair Type: Non-Urgent						
Crossing Status: Found						
UCIP Comments: 04/15/2014 Need to contact owner. Heavy sediment buildup at inlet due to animal activity should be cleared. (DWR UCIP - W. Wylie)						
FIELD_STRUCT_DESC: 24-inch corrugated metal gravity drainage pipe through the levee, 9.8 feet below the crown. Flap gate on the waterside (WS) end. Wooden weir on concrete headwall at the landside (LS) toe. 36-inch concrete riser at the LS toe. Concrete U-shaped headwall on the WS end. Concrete standpipe on the LS. [Additional Reference(s): DWR Levee Log, 2002. USACE San Joaquin O&M Manual 601.1, 1967, (HLM 0.85)].						
FS Date: 4/15/2014

LM Start	0.85	Rating **	M	Issue No.	34 (cont)
LM End	0.85	Issue Type +	Ma	Location *

Headwall and flapgate on WS toe.

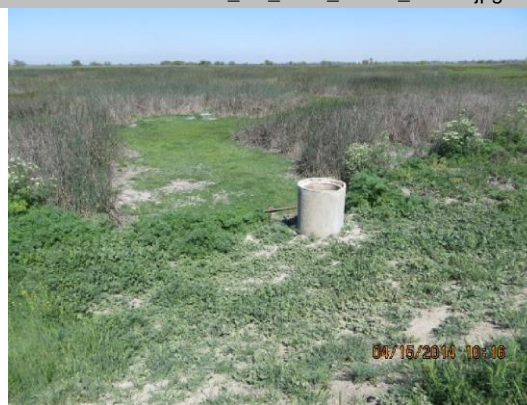
Photo 3 of 3 : UCIP_SP_2019_39507_60987.jpg

Concrete riser, concrete headwall, weir, and pipe at LS toe.

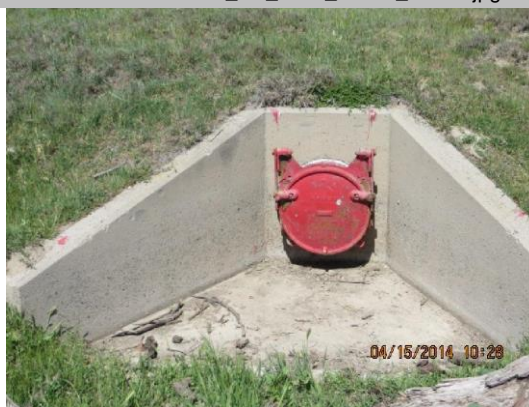
Photo 2 of 3 : UCIP_SP_2019_33725_60993.jpg

LM Start	0.94	Rating **	A/W	Issue No.	35 (cont)
LM End	0.94	Issue Type +	Ma	Location *

Concrete headwall and flapgate at WS toe.

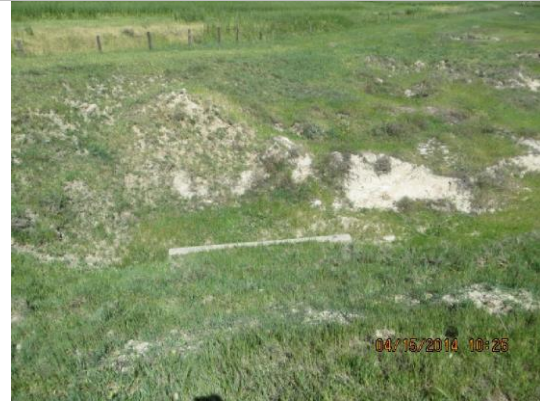
Photo 3 of 3 : UCIP_SP_2019_33725_60992.jpg

LM Start	0.94	Rating **	A/W	Issue No.	35 (cont)
LM End	0.94	Issue Type +	Ma	Location *	
Category	Supplemental			GPS Latitude/Longitude	
				Start	End
Item	DWR UCIP LMA Responsibility			37.263950 °	37.263950 °
				-120.760572 °	-120.760572 °
DWR ID	19897				
Comment Code					
Inspector Comment					
FS_ID:33725 DS_ID:19897 EP_NO: N/A Repair Type: No Action Needed Crossing Status: Found UCIP Comments: FIELD_STRUCT_DESC: 24-inch corrugated metal gravity drainage pipe through the levee, 11.5 feet below the crown. Flap gate on the waterside (WS) end. Concrete headwall on the landside (LS) end. Concrete U-shaped headwall on the WS end. [Additional Reference(s): DWR Levee Log, 2002. USACE San Joaquin O&M Manual 601.1, 1967, (HLM 0.94)]. FS Date: 4/15/2014

Concrete headwall and pipe on LS toe.

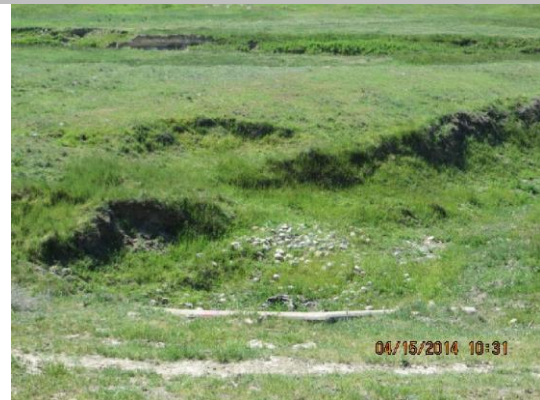
Photo 1 of 3 : UCIP_SP_2019_33726_60996.jpg

LM Start	1.17	Rating **	A/W	Issue No.	36
LM End	1.17	Issue Type +	Ma	Location *	
Category	Supplemental			GPS Latitude/Longitude	
				Start	End
Item	DWR UCIP LMA Responsibility			37.264421 °	37.264421 °
				-120.756683 °	-120.756683 °
DWR ID	19898				
Comment Code					
Inspector Comment					
FS_ID:33726					
DS_ID:19898					
EP_NO: N/A					
Repair Type: No Action Needed					
Crossing Status: Found					
UCIP Comments:					
FIELD_STRUCT_DESC: 48-inch corrugated metal gravity drainage pipe through the levee, 14.6 feet below the crown. Flap gate on the waterside (WS) end. Concrete U-shaped headwall on each end.					
[Additional Reference(s): DWR Levee Log, 2002. USACE San Joaquin O&M Manual 601.1, 1967, (HLM 1.17)].					
FS Date: 4/15/2014

Pipe, flapgate, and headwall on WS toe.

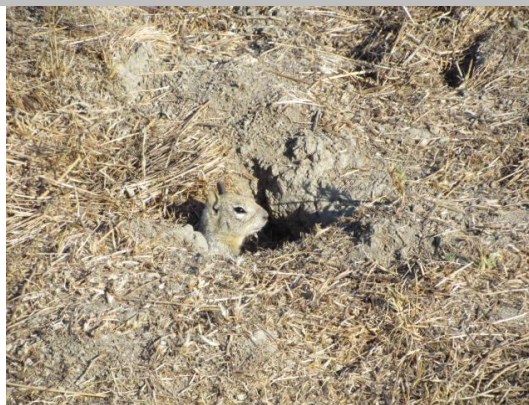
Photo 2 of 2 : SP_2019_NA0010_125_1_20190307_00002.jpg

Looking at east at active rodent holes on landside berm.

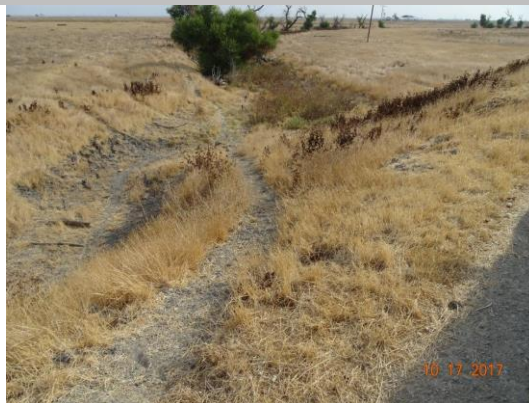
Photo 1 of 1 : SP_2019_NA0010_125_16_20190307_00007.jpg

LM Start	1.49	Rating **	M	Issue No.	16
LM End	1.49	Issue Type +	Ma	Location *	LS
Category	Earthen Levee			GPS Latitude/Longitude	
				Start	End
Item	Slope Stability			37.263999 °	37.263999 °
				-120.750854 °	-120.750854 °
DWR ID	DWR_NA0010_07_f_2017_16				
Comment Code					
S2 : Repair the levee slope damaged by foot traffic and prevent access where possible.					
Inspector Comment					
Repair slope damaged by animal traffic.

Looking east at landside slope.

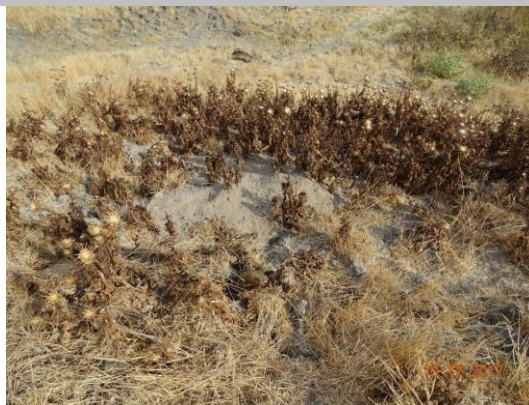
Photo 2 of 2 : SP_2019_NA0010_125_6_20190307_00004.jpg

Looking northwest at landside slope.

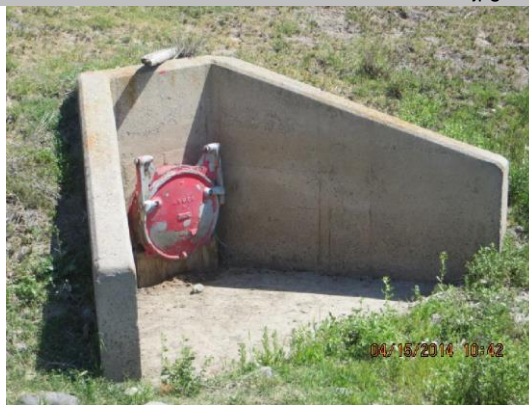
Photo 2 of 3 : UCIP_SP_2019_33727_61003.jpg

Pipe, headwall and flapgate on WS toe.

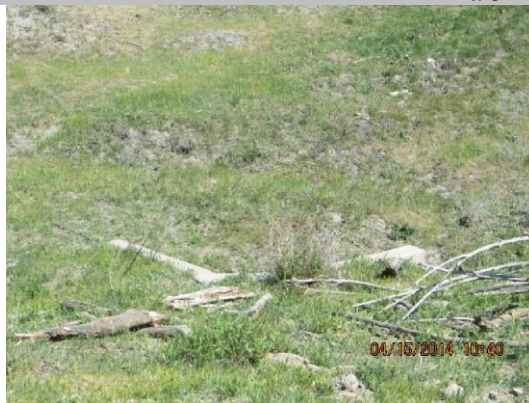
Photo 3 of 3 : UCIP_SP_2019_33727_61002.jpg

Headwall and pipe on LS toe.

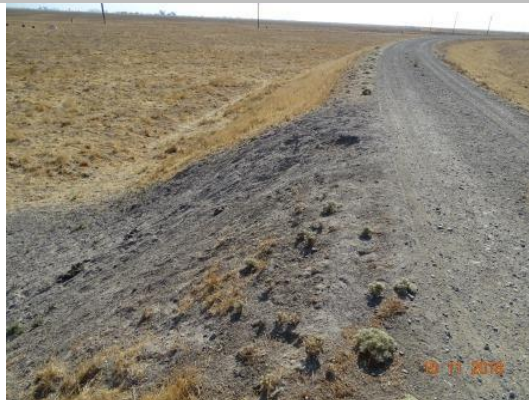
Photo 1 of 1 : SP_2019_NA0010_125_21_20190307_00011.jpg

LM Start	1.90	Rating **	M	Issue No.	21
LM End	1.90	Issue Type +	Ma	Location *	LS
Category	Earthen Levee			GPS Latitude/Longitude	
				Start	End
Item	Slope Stability			37.261379 °	37.261379 °
				-120.744228 °	-120.744228 °
DWR ID	DWR_NA0010_07_f_2018_21				
Comment Code					
S2 : Repair the levee slope damaged by foot traffic and prevent access where possible.					
Inspector Comment

Slope damage from livestock. (Fall 2018)

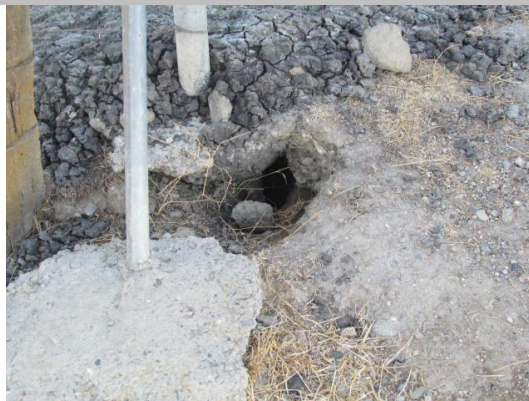
Photo 1 of 2 : SP_2019_NA0010_125_12_20190307_00005.jpg

LM Start	2.09	Rating **	M	Issue No.	12
LM End	2.09	Issue Type +	Ma	Location *	LS
Category	Earthen Levee			GPS Latitude/Longitude	
				Start	End
Item	Animal Control			37.259187 °	37.259187 °
				-120.742551 °	-120.742551 °
DWR ID	DWR_NA0010_07_f_2018_12				
Comment Code					
A3 : No rodents visible, but rodent burrows visible; need to backfill and compact or grout burrows.					
Inspector Comment					
Rodent activity is noted next to the fence post.

Looking east at rodent hole next to fence post on landward shoulder.

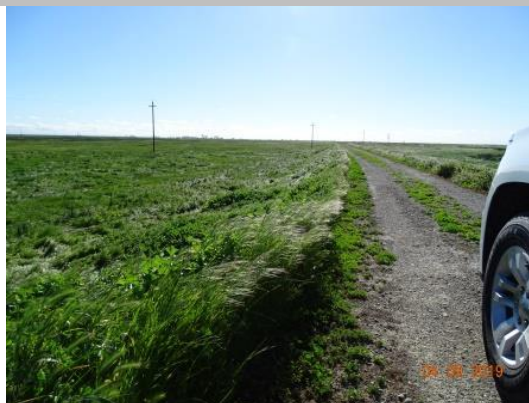
Photo 1 of 1 : SP_2019_NA0010_125_23_20190423_00049.jpg

LM Start	2.10	Rating **	U	Issue No.	23
LM End	3.61	Issue Type +	Ma	Location *	LS
Category	Earthen Levee			GPS Latitude/Longitude	
				Start	End
Item	Vegetation			37.259143 °	37.254768 °
				-120.742473 °	-120.719829 °
DWR ID	DWR_NA0010_07_s_2019_23				
Comment Code					
V1 : Control annual grass and weeds on the levee slopes and easements.					
Inspector Comment

View of landside slope looking upstream. (Spring 2019)

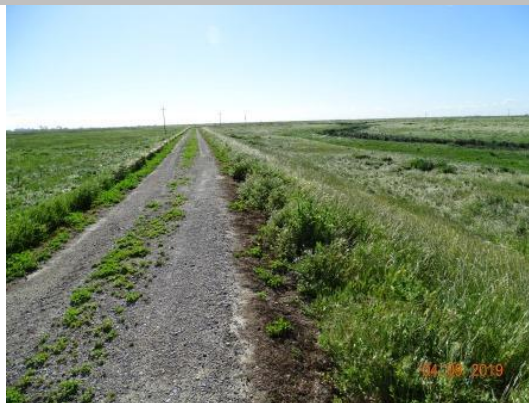
Photo 1 of 1 : SP_2019_NA0010_125_24_20190423_00050.jpg

LM Start	2.10	Rating **	U	Issue No.	24
LM End	3.61	Issue Type +	Ma	Location *	WS
Category	Earthen Levee			GPS Latitude/Longitude	
				Start	End
Item	Vegetation			37.259143 °	37.254768 °
				-120.742473 °	-120.719829 °
DWR ID	DWR_NA0010_07_s_2019_24				
Comment Code					
V1 : Control annual grass and weeds on the levee slopes and easements.					
Inspector Comment

View of waterside slope looking upstream. (Spring 2019)

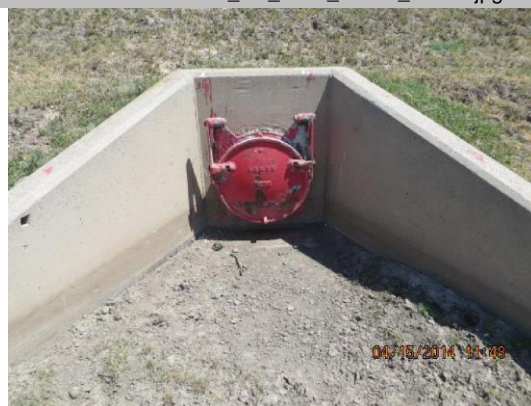
Photo 2 of 3 : UCIP_SP_2019_33729_61010.jpg

Concrete headwall and flapgate on WS toe.

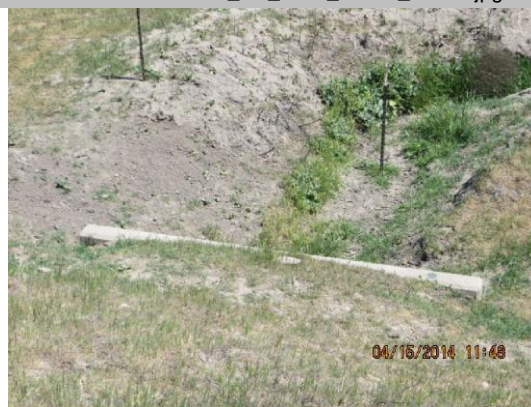
Photo 3 of 3 : UCIP_SP_2019_33729_61012.jpg

Concrete headwall and pipe at LS toe.

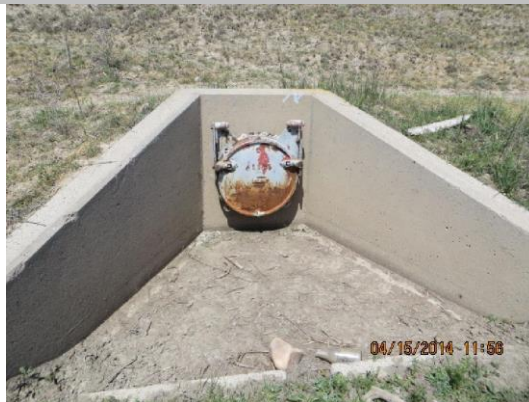
Photo 2 of 3 : UCIP_SP_2019_39508_61015.jpg

Headwall, pipe, and flapgate on WS toe.

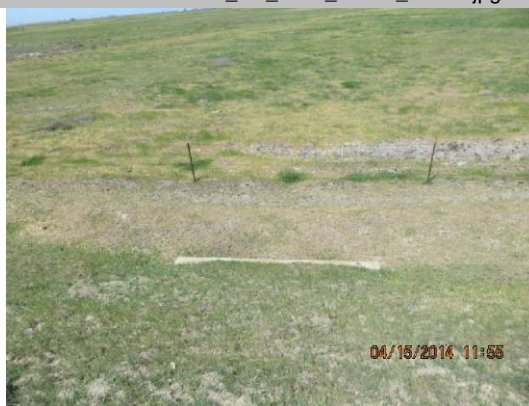
Photo 3 of 3 : UCIP_SP_2019_39508_61017.jpg

Headwall and pipe on LS toe.

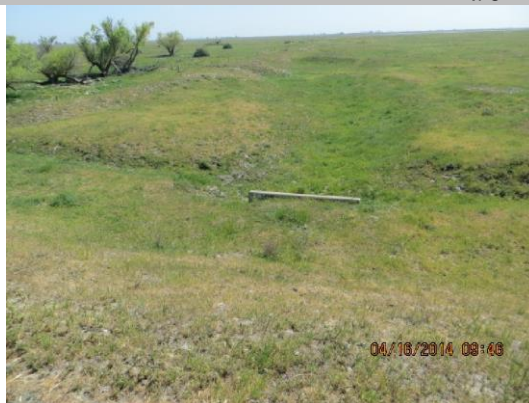
Photo 3 of 3 : UCIP_SP_2019_33752_61074.jpg

Pipe and headwall on LS toe.

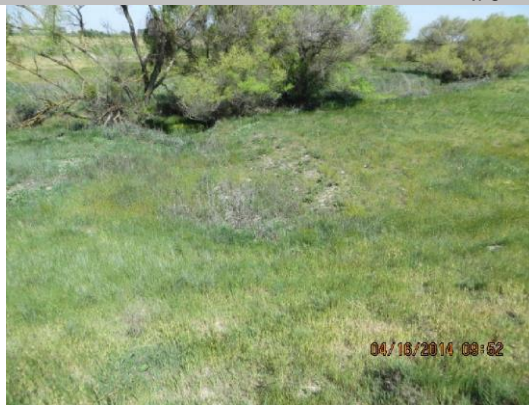
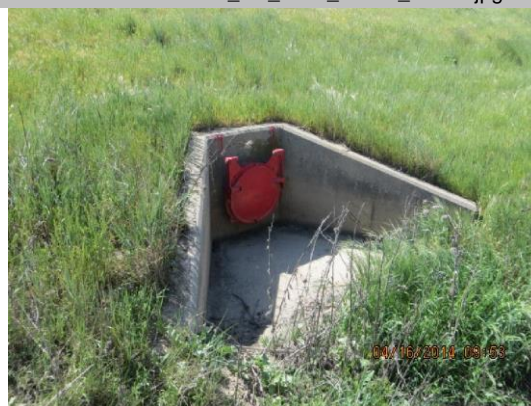
Photo 1 of 3 : UCIP_SP_2019_33753_61078.jpg

LM Start	0.72	Rating **	A/W	Issue No.	30
LM End	0.72	Issue Type +	Ma	Location *	
Category	Supplemental			GPS Latitude/Longitude	
				Start	End
Item	DWR UCIP LMA Responsibility			37.260306 °	37.260306 °
				-120.762127 °	-120.762127 °
DWR ID	19905				
Comment Code					
Inspector Comment					
FS_ID:33753 DS_ID:19905 EP_NO: N/A Repair Type: No Action Needed Crossing Status: Found UCIP Comments: FIELD_STRUCT_DESC: 24-inch corrugated metal gravity drainage pipe through the levee, 10 feet below the crown. Flap gate on the waterside (WS) end. Concrete headwall on each end. [Additional Reference(s): DWR Levee Log, 2002. USACE San Joaquin O&M Manual 601.1, 1967, (HLM 0.72)]. FS Date: 4/16/2014

Headwall and flapgate at WS toe.

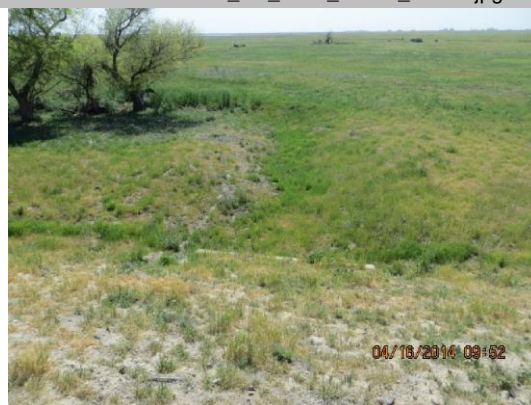
Photo 3 of 3 : UCIP_SP_2019_33753_61079.jpg

Concrete headwall on LS toe.

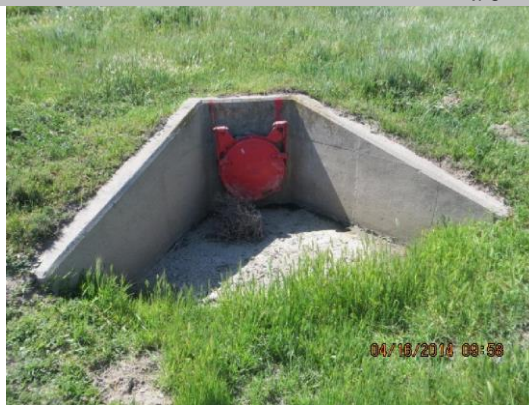
Photo 1 of 3 : UCIP_SP_2019_39887_61084.jpg

LM Start	0.90	Rating **	M	Issue No.	31
LM End	0.90	Issue Type +	Ma	Location *	
Category	Supplemental			GPS Latitude/Longitude	
				Start	End
Item	DWR UCIP LMA Responsibility			37.262384 °	37.262384 °
				-120.760528 °	-120.760528 °
DWR ID	19832				
Comment Code					
Inspector Comment					
FS_ID:39887 DS_ID:19832 EP_NO: N/A Repair Type: Non-Urgent Crossing Status: Found UCIP Comments: 04/16/2014 Some sediment buildup at inlet on LS toe. (DWR UCIP - W. Wylie) FIELD_STRUCT_DESC: 24-inch corrugated metal gravity drainage pipe through the levee, 11.5 feet below the crown. Flap gate on the waterside (WS) end. Concrete headwall on each end. [Additional Reference(s): DWR Levee Log, 2002. USACE San Joaquin O&M Manual 601.1, 1967, (HLM 0.89)]. FS Date: 4/16/2014

Headwall, pipe, and flapgate on WS toe.

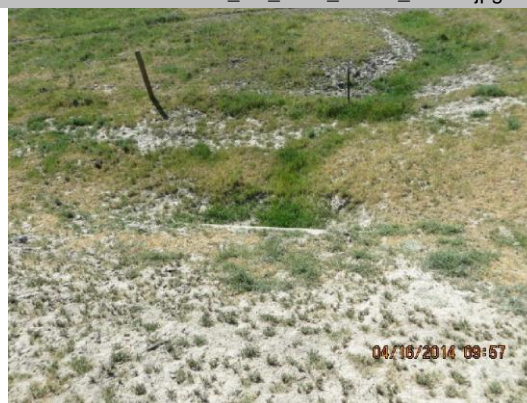
Photo 3 of 3 : UCIP_SP_2019_39887_61085.jpg

Pipe and headwall on LS toe.

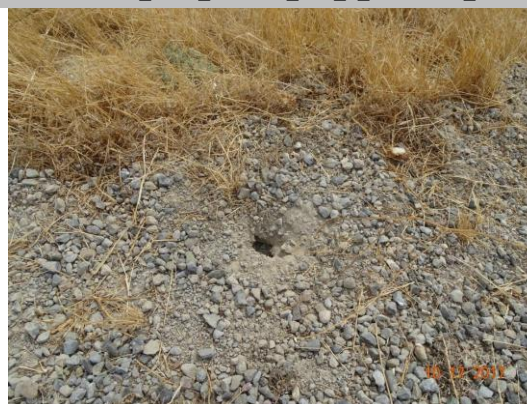
Photo 1 of 1 : SP_2019_NA0010_126_2_20190307_00001.jpg

LM Start	1.20	Rating **	M	Issue No.	2
LM End	1.20	Issue Type +	Ma	Location *	LS
Category	Earthen Levee			GPS Latitude/Longitude	
				Start	End
Item	Animal Control			37.263182 °	37.263183 °
				-120.755650 °	-120.755637 °
DWR ID	DWR_NA0010_08_s_2012_2				
Comment Code					
A3 : No rodents visible, but rodent burrows visible; need to backfill and compact or grout burrows.					
Inspector Comment

Looking south at the landside shoulder.

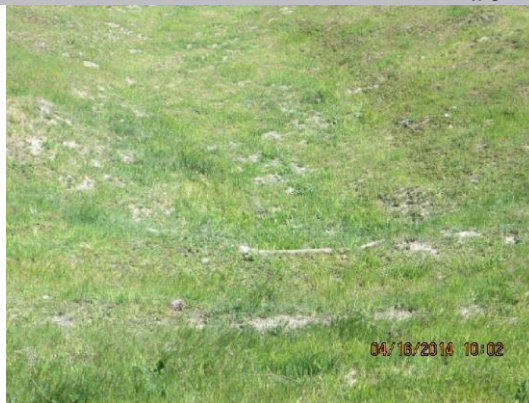
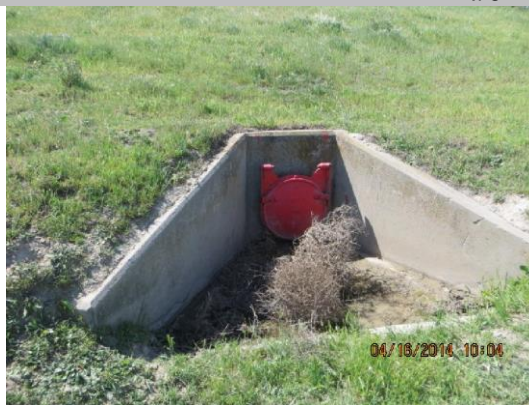
Photo 1 of 3 : UCIP_SP_2019_39509_61090.jpg

LM Start	1.21	Rating **	M	Issue No.	32	
LM End	1.21	Issue Type +	Ma	Location *		
Category	Supplemental			GPS Latitude/Longitude		
				Start		End
Item	DWR UCIP LMA Responsibility			37.263188 °		37.263188 °
				-120.755399 °		-120.755399 °
DWR ID	19833					
Comment Code						
Inspector Comment						
FS_ID:39509 DS_ID:19833 EP_NO: N/A Repair Type: Non-Urgent Crossing Status: Found UCIP Comments: 04/16/2014 Debris blocking landward headwall--recommend clearing. (DWR UCIP - W. Wylie) FIELD_STRUCT_DESC: 24-inch corrugated metal gravity drainage pipe through the levee, 11.6 feet below the crown. Flap gate on the waterside (WS) end. Concrete headwall on each end. [Additional Reference(s): DWR Levee Log, 2002. USACE San Joaquin O&M Manual 601.1, 1967, (HLM 1.21)]. FS Date: 4/16/2014

Concrete headwall, pipe, and flapgate on WS toe.

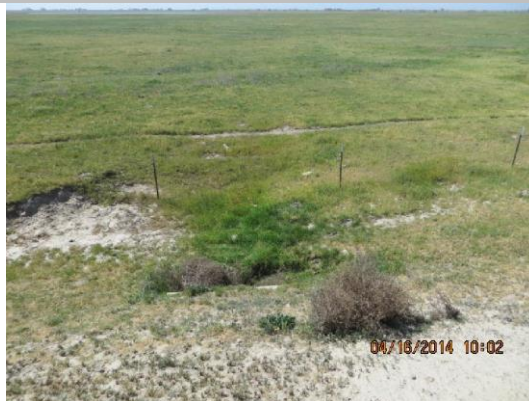
Photo 3 of 3 : UCIP_SP_2019_39509_61089.jpg

Pipe and headwall on LS toe.

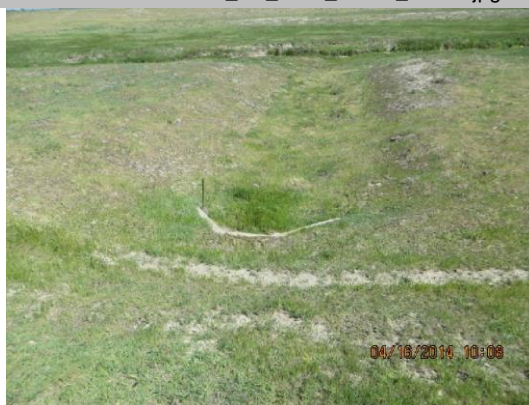
Photo 1 of 3 : UCIP_SP_2019_39510_61094.jpg

LM Start	1.38	Rating **	M	Issue No.	33
LM End	1.38	Issue Type +	Ma	Location *	
Category	Supplemental			GPS Latitude/Longitude	
				Start	End
Item	DWR UCIP LMA Responsibility			37.263194 °	37.263194 °
				-120.752299 °	-120.752299 °
DWR ID	19834				
Comment Code					
Inspector Comment					
FS_ID:39510 DS_ID:19834 EP_NO: N/A Repair Type: Non-Urgent Crossing Status: Found UCIP Comments: 04/16/2014 Animal burrows along pipe alignment on LS. Some sediment buildup at LS toe and inside pipe--recommend clearing. (DWR UCIP - W. Wylie) FIELD_STRUCT_DESC: 24-inch corrugated metal gravity drainage pipe through the levee, 11.5 feet below the crown. Flap gate on the waterside (WS) end. Concrete headwall on each end. [Additional Reference(s): DWR Levee Log, 2002. USACE San Joaquin O&M Manual 601.1, 1967, (HLM 1.38)]. FS Date: 4/16/2014

Pipe, headwall, and flapgate on WS toe.

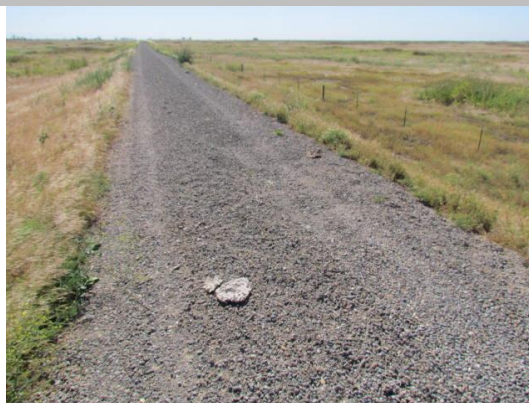
Photo 1 of 1 : SP_2019_NA0010_126_5_20190307_00004.jpg

LM Start	2.01	Rating **	A/W	Issue No.	5
LM End	3.18	Issue Type +	Ma	Location *	CR
Category	Earthen Levee			GPS Latitude/Longitude	
				Start	End
Item	Crown Surface / Depressions / Rutting			37.258410 °	37.251737 °
				-120.743412 °	-120.726246 °
DWR ID	DWR_NA0010_08_s _ 2016_5				
Comment Code					
C2 : Repair depressions or ruts in the crown or slope.					
Inspector Comment					
A depression is noted on the levee crown.

Looking west at depression on toward landward shoulder.

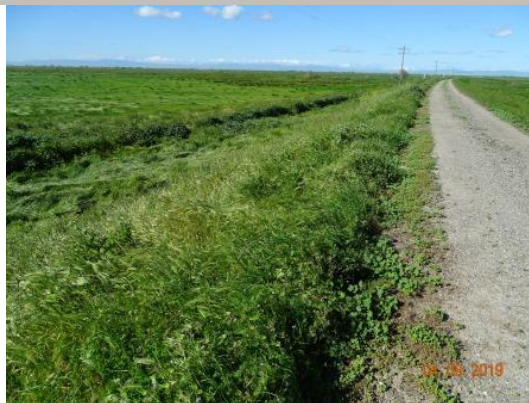
Photo 1 of 1 : SP_2019_NA0010_126_23_20190423_00044.jpg

LM Start	2.04	Rating **	U	Issue No.	23
LM End	3.62	Issue Type +	Ma	Location *	LS
Category	Earthen Levee			GPS Latitude/Longitude	
				Start	End
Item	Vegetation			37.258261 °	37.254014 °
				-120.742962 °	-120.718880 °
DWR ID	DWR_NA0010_08_s_2019_23				
Comment Code					
V1 : Control annual grass and weeds on the levee slopes and easements.					
Inspector Comment

View of landside slope looking downstream. (Spring 2019)

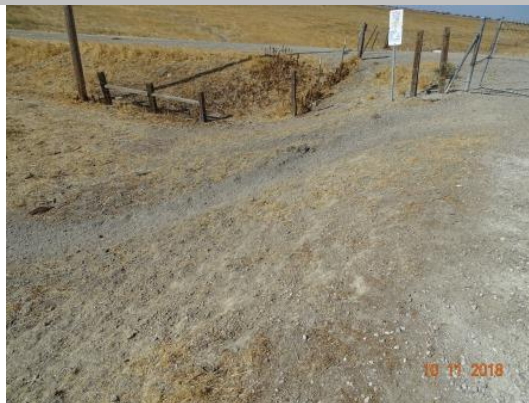
Photo 1 of 1 : SP_2019_NA0010_126_22_20190307_00007.jpg

LM Start	2.07	Rating **	M	Issue No.	22
LM End	2.07	Issue Type +	Ma	Location *	LS
Category	Earthen Levee			GPS Latitude/Longitude	
				Start	End
Item	Slope Stability			37.258076 °	37.258076 °
				-120.742439 °	-120.742439 °
DWR ID	DWR_NA0010_08_f_2018_22				
Comment Code					
Inspector Comment					
There is damage to the slope and shoulder from livestock.

Slope and shoulder damage from livestock. (Fall 2018)

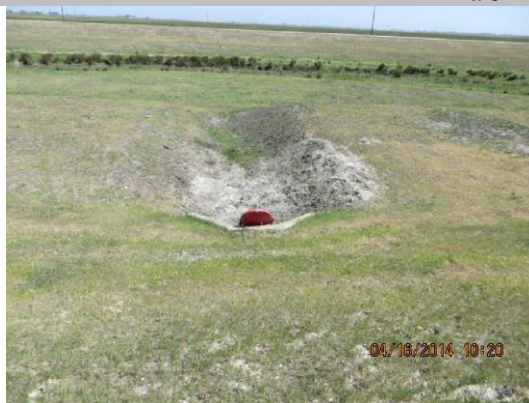
Photo 1 of 3 : UCIP_SP_2019_39512_61102.jpg

LM Start	2.12	Rating **	M	Issue No.	35
LM End	2.12	Issue Type +	Ma	Location *	
Category	Supplemental			GPS Latitude/Longitude	
				Start	End
Item	DWR UCIP LMA Responsibility			37.257800 °	37.257800 °
				-120.741604 °	-120.741604 °
DWR ID	19836				
Comment Code					
Inspector Comment					
FS_ID:39512 DS_ID:19836 EP_NO: N/A Repair Type: Non-Urgent Crossing Status: Found UCIP Comments: 04/16/2014 Sediment buildup in pipe visible from landward side. (DWR UCIP - W. Wylie) FIELD_STRUCT_DESC: 24-inch corrugated metal gravity drainage pipe through the levee, 9.5 feet below the crown. Flap gate on the waterside (WS) end. Concrete headwall on each end. [Additional Reference(s): DWR Levee Log, 2002. USACE San Joaquin O&M Manual 601.1, 1967, (HLM 2.12)]. FS Date: 4/16/2014

Pipe, headwall, and flapgate on WS toe.

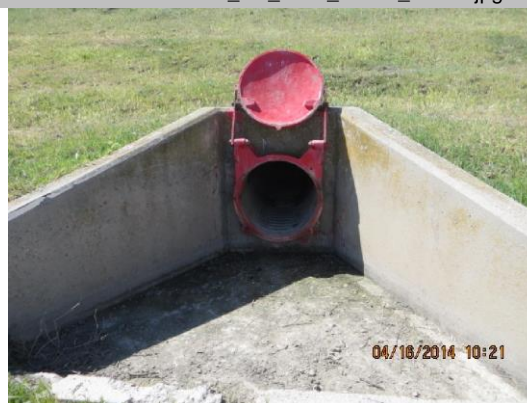
Photo 2 of 3 : UCIP_SP_2019_39512_61100.jpg

Pipe, headwall, and flapgate on WS toe.

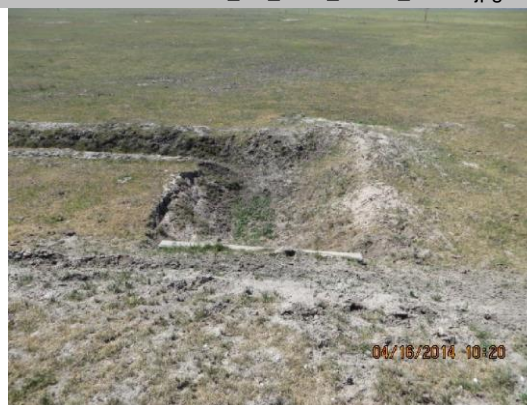
Photo 3 of 3 : UCIP_SP_2019_39512_61101.jpg

Pipe and headwall on LS toe.

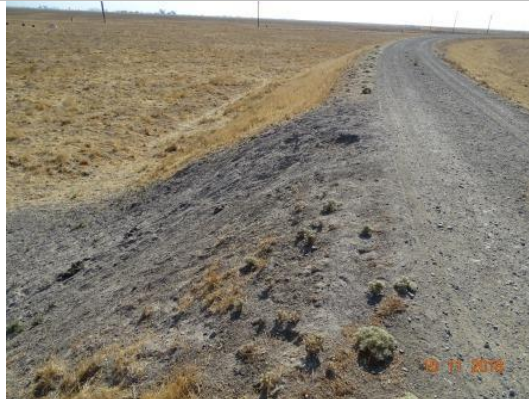
Photo 1 of 1 : SP_2019_NA0010_126_20_20190307_00006.jpg

LM Start	2.74	Rating **	A/W	Issue No.	20
LM End	2.74	Issue Type +	Ma	Location *	LS
Category	Earthen Levee			GPS Latitude/Longitude	
				Start	End
Item	Slope Stability			37.252503 °	37.252503 °
				-120.733282 °	-120.733282 °
DWR ID	DWR_NA0010_08_f_2018_20				
Comment Code					
S2 : Repair the levee slope damaged by foot traffic and prevent access where possible.					
Inspector Comment					
There is minor erosion to the slope and shoulder.

Minor erosion to shoulder and slope from livestock. (Fall 2018)

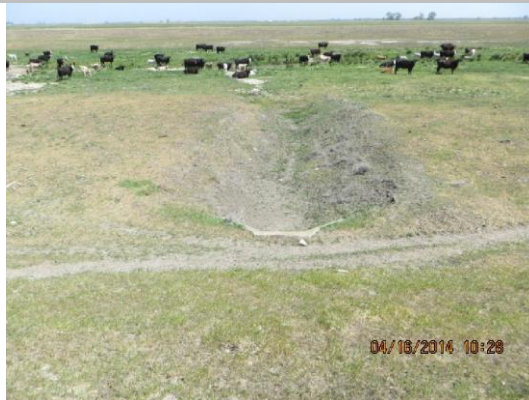
Photo 1 of 3 : UCIP_SP_2019_33760_61107.jpg

LM Start	2.77	Rating **	A/W	Issue No.	36
LM End	2.77	Issue Type +	Ma	Location *	
Category	Supplemental			GPS Latitude/Longitude	
				Start	End
Item	DWR UCIP LMA Responsibility			37.252228 °	37.252228 °
				-120.732890 °	-120.732890 °
DWR ID	19837				
Comment Code					
Inspector Comment					
FS_ID:33760					
DS_ID:19837					
EP_NO: N/A					
Repair Type: No Action Needed					
Crossing Status: Found					
UCIP Comments:					
FIELD_STRUCT_DESC: 24-inch corrugated metal gravity drainage pipe through the levee, 10.5 feet below the crown. Flap gate on the waterside (WS) end. Concrete headwall on each end. [Additional Reference(s): DWR Levee Log, 2002. USACE San Joaquin O&M Manual 601.1, 1967, (HLM 2.77)].					
FS Date: 4/16/2014

Pipe, headwall, and flapgate on WS toe.

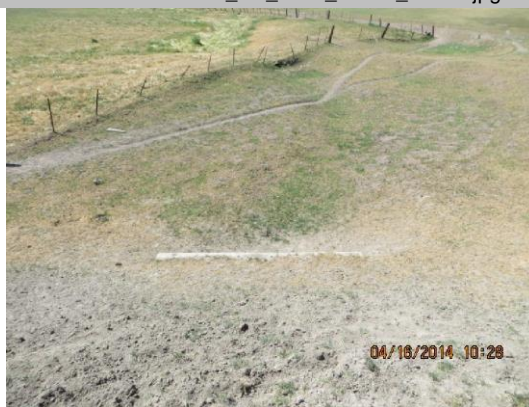
Photo 3 of 3 : UCIP_SP_2019_33760_61106.jpg

Pipe and headwall on LS toe.

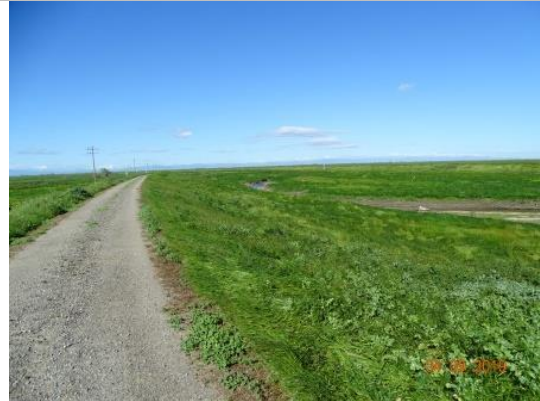
Photo 1 of 1 : SP_2019_NA0010_126_24_20190423_00045.jpg

LM Start	3.02	Rating **	U	Issue No.	24
LM End	3.62	Issue Type +	Ma	Location *	WS
Category	Earthen Levee			GPS Latitude/Longitude	
				Start	End
Item	Vegetation			37.250761 °	37.254014 °
				-120.728918 °	-120.718880 °
DWR ID	DWR_NA0010_08_s_2019_24				
Comment Code					
V1 : Control annual grass and weeds on the levee slopes and easements.					
Inspector Comment

View of waterside slope looking downstream. (Spring 2019)

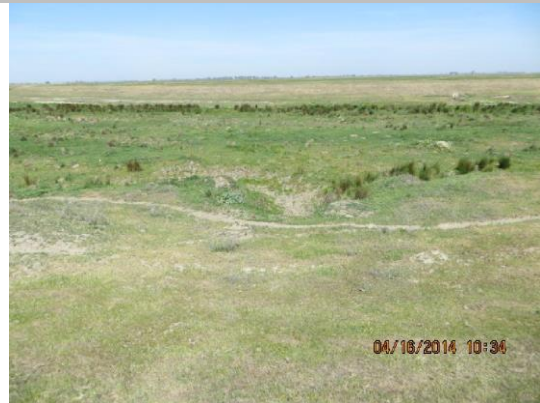
Photo 1 of 3 : UCIP_SP_2019_49969_61112.jpg

Comment Code						
Inspector Comment						
FS_ID:49969 DS_ID:19838 EP_NO: N/A Repair Type: Non-Urgent Crossing Status: Found UCIP Comments: 7/20/2016 LS inlet buried under dense vegetation. Dense vegetation limits the inspector's visibility to identify signs of pipe failure (leaks) along the WS and LS slope. Recommend removing vegetation along pipe alignment to conduct proper inspection of structure and appurtenances. (DWR UCIP - omagana)4/16/2014 Pipe blocked by silt on LS toe. Flapgate rusty and does not operate correctly. (DWR UCIP - wwylie) FIELD_STRUCT_DESC: 36-inch corrugated metal gravity drainage pipe through the levee, 13.4 feet below the crown. Flap gate on the waterside (WS) end. Concrete headwall on each end. [Additional Reference(s): DWR Levee Log, 2002. USACE San Joaquin O&M Manual 601.1, 1967, (HLM 3.06)]. FS Date: 7/20/2016

Pipe, headwall, and flapgate on WS toe.

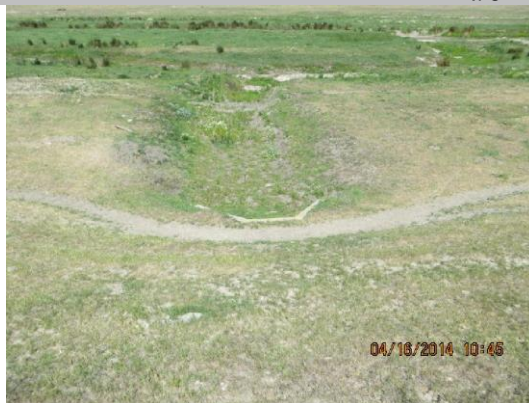
Photo 1 of 3 : UCIP_SP_2019_33764_61128.jpg

LM Start	3.24	Rating **	A/W	Issue No.	38
LM End	3.24	Issue Type +	Ma	Location *	
Category	Supplemental			GPS Latitude/Longitude	
				Start	End
Item	DWR UCIP LMA Responsibility			37.252230 °	37.252230 °
				-120.725504 °	-120.725504 °
DWR ID	19839				
Comment Code					
Inspector Comment					
FS_ID:33764					
DS_ID:19839					
EP_NO: N/A					
Repair Type: No Action Needed					
Crossing Status: Found					
UCIP Comments:					
FIELD_STRUCT_DESC: 24-inch corrugated metal gravity drainage pipe through the levee, 10 feet below the crown. Flap gate on the waterside (WS) end. Concrete headwall on each end. [Additional Reference(s): DWR Levee Log, 2002. USACE San Joaquin O&M Manual 601.1, 1967, (HLM 3.24)].					
FS Date: 4/16/2014

Pipe, flapgate, and headwall on WS toe.

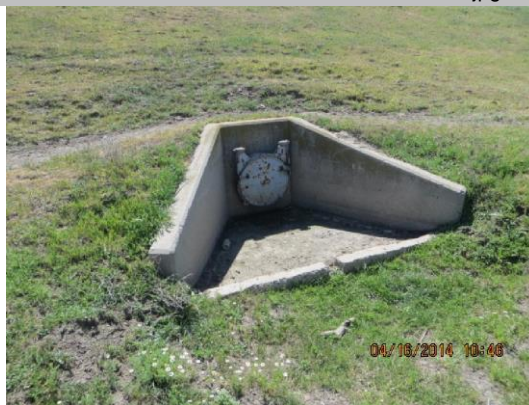
Photo 2 of 3 : UCIP_SP_2019_33764_61127.jpg

Pipe, flapgate, and headwall on WS toe.

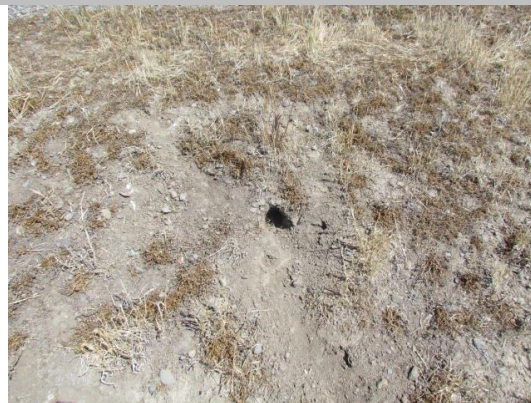
Photo 2 of 2 : SP_2019_NA0010_126_3_20190307_00003.jpg

LM Start	3.40	Rating **	M	Issue No.	3 (cont)	
LM End	3.54	Issue Type +	Ma	Location *	LS	
Category	Earthen Levee			GPS Latitude/Longitude		
				Start		End
Item	Animal Control			37.253052 °		37.253600 °
				-120.722647 °		-120.720198 °
DWR ID	DWR_NA0010_08_s_2012_3					
Comment Code						
A3 : No rodents visible, but rodent burrows visible; need to backfill and compact or grout burrows.						
Inspector Comment						
Several rodent holes were noted on landside slope within this reach.

Looking at typical view of rodent holes on landward slope.

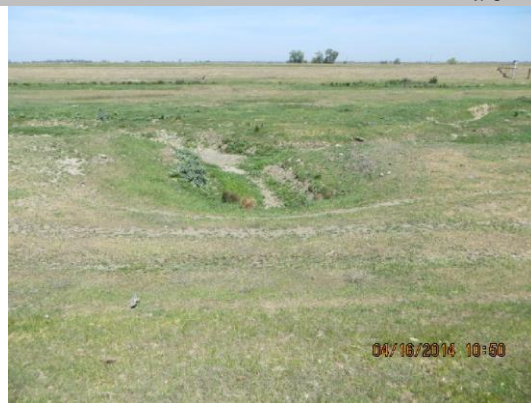
Photo 1 of 3 : UCIP_SP_2019_39513_61134.jpg

LM Start	3.43	Rating **	M	Issue No.	39
LM End	3.43	Issue Type +	Ma	Location *	
Category	Supplemental			GPS Latitude/Longitude	
				Start	End
Item	DWR UCIP LMA Responsibility			37.253151 °	37.253151 °
				-120.722182 °	-120.722182 °
DWR ID	19840				
Comment Code					
Inspector Comment					
FS_ID:39513 DS_ID:19840 EP_NO: N/A Repair Type: Non-Urgent Crossing Status: Found UCIP Comments: 04/16/2014 No access available on landward side. Need to confirm status of crossing. (DWR UCIP - W. Wylie) FIELD_STRUCT_DESC: 24-inch corrugated metal gravity drainage pipe through the levee, 13 feet below the crown. Flap gate on the waterside (WS) end. Concrete headwall on each end. [Additional Reference(s): DWR Levee Log, 2002. USACE San Joaquin O&M Manual 601.1, 1967, (HLM 3.43)]. FS Date: 4/16/2014

Pipe, headwall, and flapgate on WS toe.

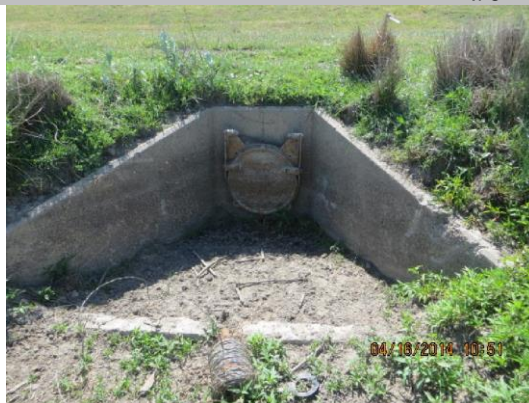
Photo 2 of 3 : UCIP_SP_2019_39513_61133.jpg

Pipe, headwall, and flapgate on WS toe.

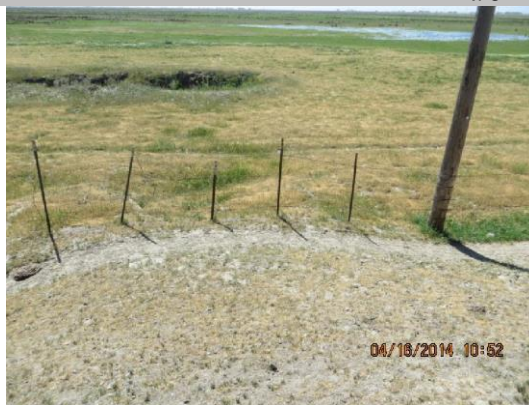
Photo 3 of 3 : UCIP_SP_2019_39513_61132.jpg

Pipe likely at drainage swale off LS toe.

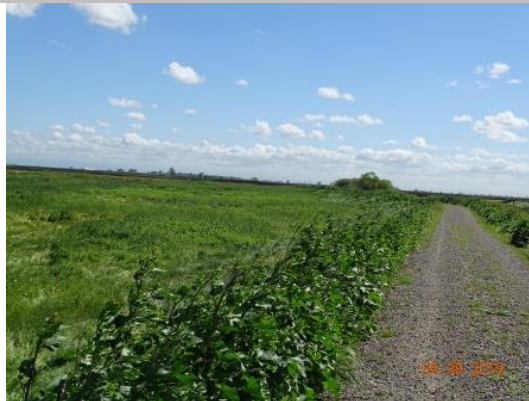
Photo 1 of 1 : SP_2019_NA0010_127_5_20190426_00015.jpg

LM Start	0.02	Rating **	U	Issue No.	5
LM End	0.87	Issue Type +	Ma	Location *	LS
Category	Earthen Levee			GPS Latitude/Longitude	
				Start	End
Item	Vegetation			37.220005 °	37.220051 °
				-120.712852 °	-120.698286 °
DWR ID	DWR_NA0010_09_s_2019_5				
Comment Code					
V1 : Control annual grass and weeds on the levee slopes and easements.					
Inspector Comment

View of landside slope looking upstream. (Spring 2019)

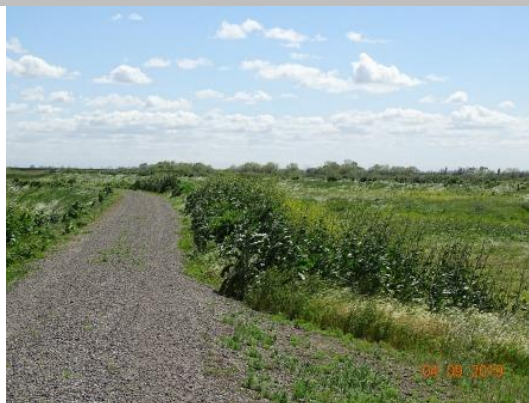
Photo 1 of 1 : SP_2019_NA0010_127_6_20190426_00013.jpg

LM Start	0.02	Rating **	U	Issue No.	6
LM End	0.87	Issue Type +	Ma	Location *	WS
Category	Earthen Levee			GPS Latitude/Longitude	
				Start	End
Item	Vegetation			37.220005 °	37.220051 °
				-120.712852 °	-120.698286 °
DWR ID	DWR_NA0010_09_s_2019_6				
Comment Code					
V1 : Control annual grass and weeds on the levee slopes and easements.					
Inspector Comment

View of waterside slope looking upstream. (Spring 2019)

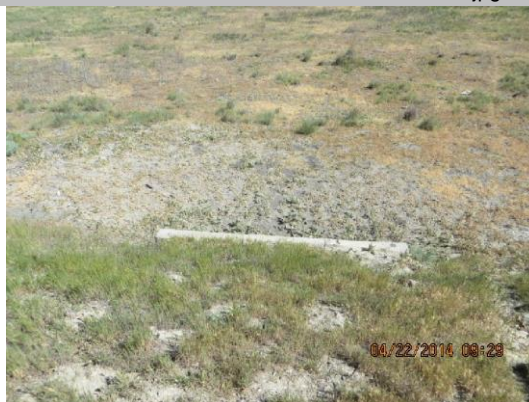
Photo 3 of 3 : UCIP_SP_2019_39515_62129.jpg

Headwall and pipe on LS toe.

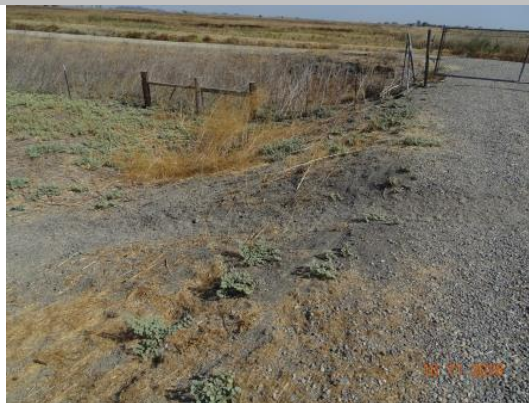
Photo 1 of 2 : SP_2019_NA0010_127_4_20190307_00001.jpg

LM Start	0.86	Rating **	M	Issue No.	4
LM End	0.86	Issue Type +	Ma	Location *	LS
Category	Earthen Levee			GPS Latitude/Longitude	
				Start	End
Item	Slope Stability			37.220041 °	37.220041 °
				-120.698425 °	-120.698425 °
DWR ID	DWR_NA0010_09_f_2017_4				
Comment Code					
S2 : Repair the levee slope damaged by foot traffic and prevent access where possible.					
Inspector Comment

View of slope erosion due to foot traffic. (Fall 2018)

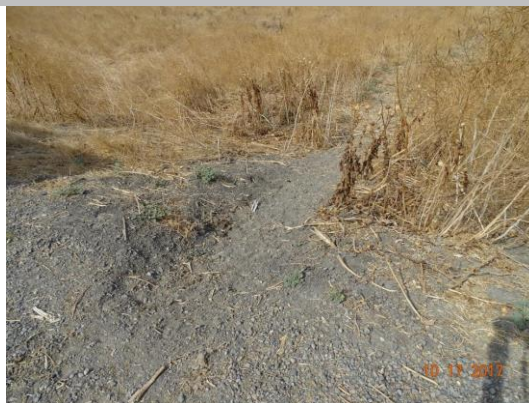
Photo 2 of 2 : SP_2019_NA0010_127_4_20190307_00002.jpg

Looking northwest at landside slope. (Fall 2017)

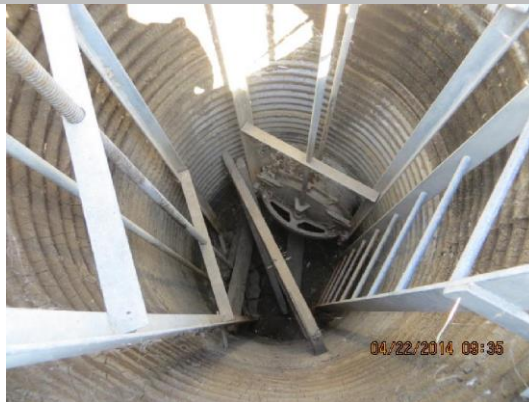
Photo 2 of 3 : UCIP_SP_2019_34186_62133.jpg

Inside CMP riser on WS slope.

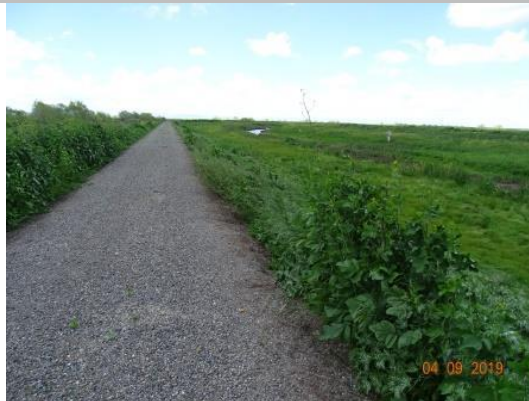
Photo 1 of 1 : SP_2019_NA0010_128_2_20190426_00005.jpg

LM Start	0.01	Rating **	U	Issue No.	2
LM End	0.79	Issue Type +	Ma	Location *	WS
Category	Earthen Levee			GPS Latitude/Longitude	
				Start	End
Item	Vegetation			37.217967 °	37.219354 °
				-120.711414 °	-120.698032 °
DWR ID	DWR_NA0010_10_s_2019_2				
Comment Code					
V1 : Control annual grass and weeds on the levee slopes and easements.					
Inspector Comment

View of waterside slope looking downstream. (Spring 2019)

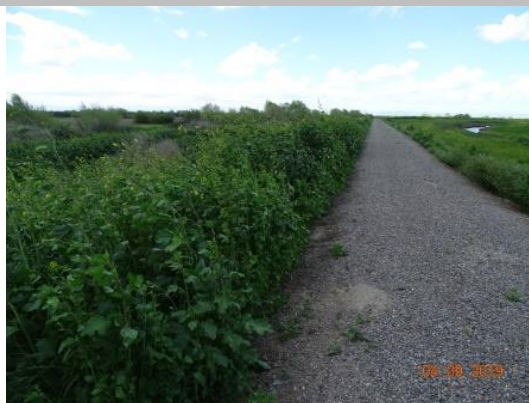
Photo 1 of 1 : SP_2019_NA0010_128_3_20190426_00006.jpg

LM Start	0.01	Rating **	U	Issue No.	3
LM End	0.79	Issue Type +	Ma	Location *	LS
Category	Earthen Levee			GPS Latitude/Longitude	
				Start	End
Item	Vegetation			37.217968 °	37.219354 °
				-120.711413 °	-120.698032 °
DWR ID	DWR_NA0010_10_s_2019_3				
Comment Code					
V1 : Control annual grass and weeds on the levee slopes and easements.					
Inspector Comment

View of landside slope looking downstream. (Spring 2019)

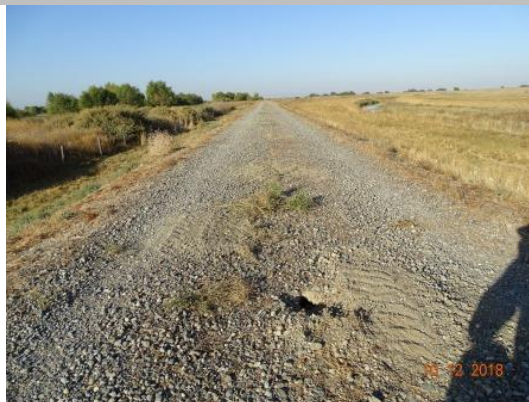
Photo 1 of 1 : SP_2019_NA0010_128_4_20190307_00001.jpg

LM Start	0.74	Rating **	A/W	Issue No.	4
LM End	0.76	Issue Type +	Ma	Location *	CR
Category	Earthen Levee			GPS Latitude/Longitude	
				Start	End
Item	Animal Control			37.219200 °	37.219258 °
				-120.699013 °	-120.698629 °
DWR ID	DWR_NA0010_10_f_2018_4				
Comment Code					
A3 : No rodents visible, but rodent burrows visible; need to backfill and compact or grout burrows.					
Inspector Comment					
There are rodent holes in the crown.

View of rodent holes in crown of the levee (Fall 2018)

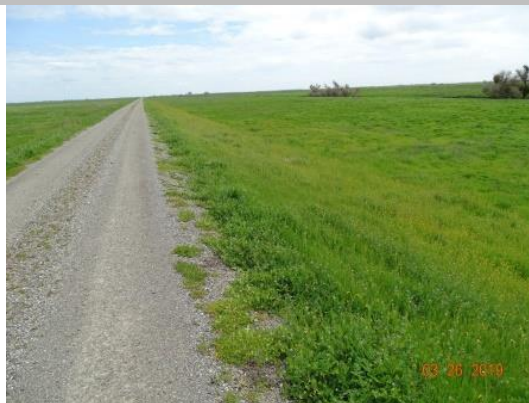
Photo 1 of 1 : SP_2019_NA0010_129_14_20190419_00029.jpg

LM Start	0.01	Rating **	M	Issue No.	14
LM End	0.72	Issue Type +	Ma	Location *	WS
Category	Earthen Levee			GPS Latitude/Longitude	
				Start	End
Item	Vegetation			37.202736 °	37.202752 °
				-120.755013 °	-120.742177 °
DWR ID	DWR_NA0010_11_s_2019_14				
Comment Code					
V1 : Control annual grass and weeds on the levee slopes and easements.					
Inspector Comment

View of waterside slope looking upstream. (Spring 2019)

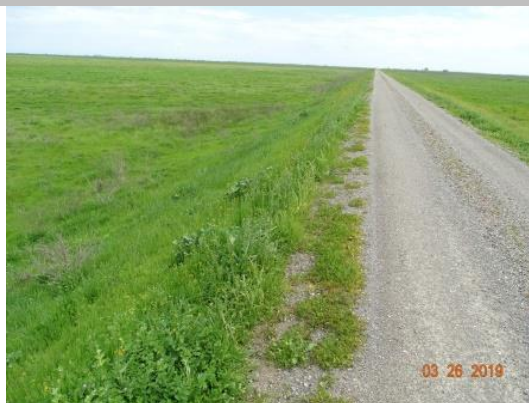
Photo 1 of 1 : SP_2019_NA0010_129_13_20190419_00030.jpg

LM Start	0.01	Rating **	M	Issue No.	13
LM End	0.72	Issue Type +	Ma	Location *	LS
Category	Earthen Levee			GPS Latitude/Longitude	
				Start	End
Item	Vegetation			37.202735 °	37.202752 °
				-120.755012 °	-120.742192 °
DWR ID	DWR_NA0010_11_s_2019_13				
Comment Code					
V1 : Control annual grass and weeds on the levee slopes and easements.					
Inspector Comment

View of landside slope looking upstream. (Spring 2019)

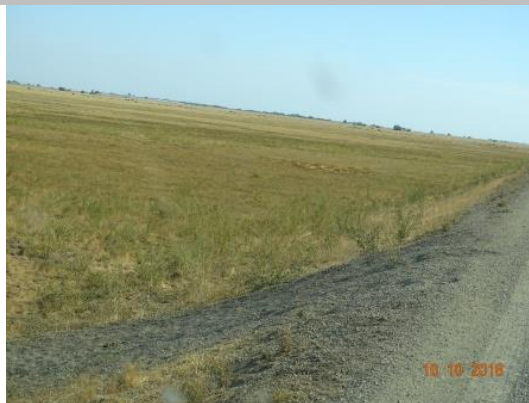
Photo 1 of 2 : SP_2019_NA0010_129_10_20190307_00002.jpg

LM Start	0.16	Rating **	M	Issue No.	10
LM End	0.16	Issue Type +	Ma	Location *	LS
Category	Earthen Levee			GPS Latitude/Longitude	
				Start	End
Item	Slope Stability			37.202730 °	37.202730 °
				-120.752270 °	-120.752270 °
DWR ID	DWR_NA0010_11_f_2018_10				
Comment Code					
S2 : Repair the levee slope damaged by foot traffic and prevent access where possible.					
Inspector Comment					
Slope damage is from livestock crossing.

View looking upstream of slope damage from livestock. (Fall 2018)

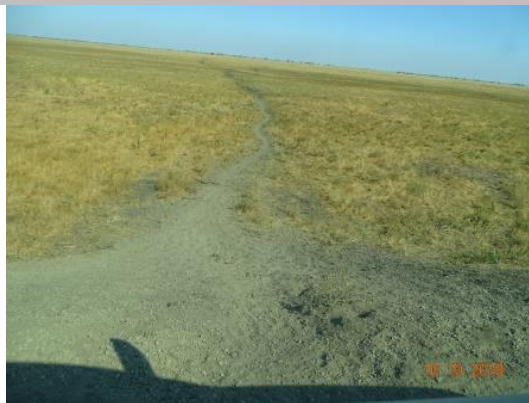
Photo 2 of 2 : SP_2019_NA0010_129_10_20190307_00003.jpg

LM Start	0.16	Rating **	M	Issue No.	10 (cont)	
LM End	0.16	Issue Type +	Ma	Location *	LS	
Category	Earthen Levee			GPS Latitude/Longitude		
				Start		End
Item	Slope Stability			37.202730 °		37.202730 °
				-120.752270 °		-120.752270 °
DWR ID	DWR_NA0010_11_f_2018_10					
Comment Code						
S2 : Repair the levee slope damaged by foot traffic and prevent access where possible.						
Inspector Comment						
Slope damage is from livestock crossing.

Looking north down the levee slope. (Fall 2018)

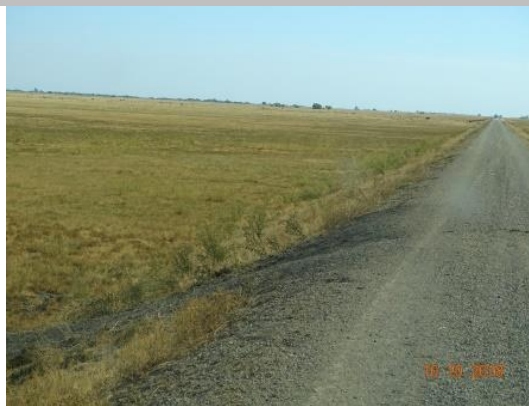
Photo 1 of 2 : SP_2019_NA0010_129_11_20190307_00004.jpg

LM Start	0.21	Rating **	M	Issue No.	11
LM End	0.21	Issue Type +	Ma	Location *	LS
Category	Earthen Levee			GPS Latitude/Longitude	
				Start	End
Item	Slope Stability			37.202731 °	37.202731 °
				-120.751389 °	-120.751389 °
DWR ID	DWR_NA0010_11_f_2018_11				
Comment Code					
S2 : Repair the levee slope damaged by foot traffic and prevent access where possible.					
Inspector Comment					
Damage is from livestock on the land and water side slopes.

View of slope damage on landside. (Fall 2018)

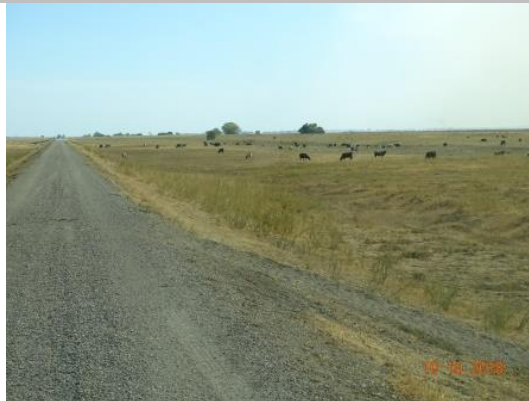
Photo 2 of 2 : SP_2019_NA0010_129_11_20190307_00005.jpg

View of damage on waterside. (Fall 2018)

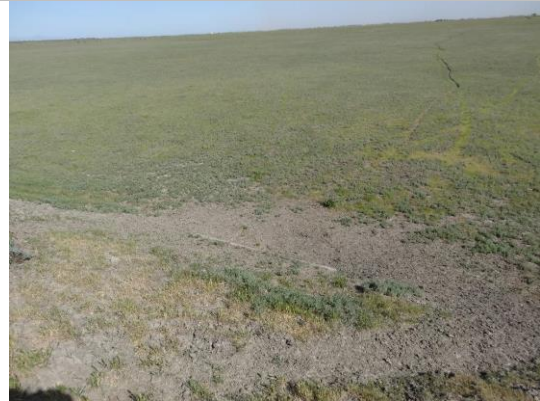
Photo 3 of 3 : UCIP_SP_2019_39517_66642.jpg

LM Start	0.42	Rating **	M	Issue No.	17 (cont)	
LM End	0.42	Issue Type +	Ma	Location *		
Category	Supplemental			GPS Latitude/Longitude		
				Start	End	
Item	DWR UCIP LMA Responsibility			37.202754 °	37.202754 °	
				-120.747689 °	-120.747689 °	
DWR ID	19846					
Comment Code						
Inspector Comment						
FS_ID:39517 DS_ID:19846 EP_NO: N/A Repair Type: Non-Urgent Crossing Status: Found UCIP Comments: 04/18/2014 Need to contact owner. Recommend clearing sediment deposit inside pipe. (DWR UCIP - O. Magana) FIELD_STRUCT_DESC: 24-inch corrugated metal gravity drainage pipe through the levee, 11 feet below the crown. Slide gate in a corrugated metal pipe (CMP) riser on the waterside (WS) end. [Additional Reference(s): DWR Levee Log, 2002. USACE San Joaquin O&M Manual 601.1, 1967, (HLM 0.42)]. FS Date: 4/18/2014

View of landward side.

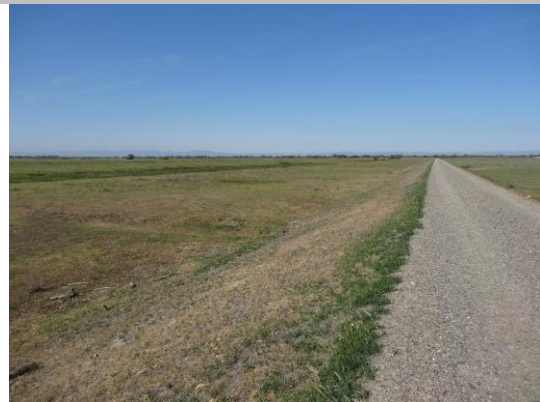
Photo 1 of 3 : UCIP_SP_2019_39518_61997.jpg

LM Start	0.65	Rating **	M	Issue No.	18
LM End	0.65	Issue Type +	Ma	Location *	
Category	Supplemental			GPS Latitude/Longitude	
				Start	End
Item	DWR UCIP LMA Responsibility			37.202751 °	37.202751 °
				-120.743474 °	-120.743474 °
DWR ID	19847				
Comment Code					
Inspector Comment					
FS_ID:39518					
DS_ID:19847					
EP_NO: N/A					
Repair Type: Non-Urgent					
Crossing Status: Found					
UCIP Comments: 04/18/2014 Need to contact owner. Recommend clearing sediment deposit inside pipe. (DWR UCIP - O. Magana)					
FIELD_STRUCT_DESC: 24-inch corrugated metal gravity drainage pipe through the levee, 10 feet below the crown. Flap gate on the waterside (WS) end. [Additional Reference(s): DWR Levee Log, 2002. USACE San Joaquin O&M Manual 601.1, 1967, (HLM 0.65)].					
FS Date: 4/18/2014

View of waterward side.

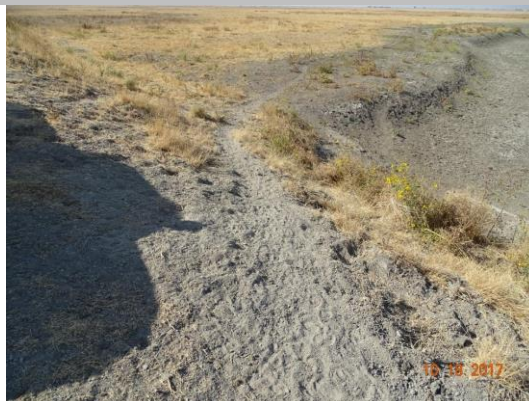
Photo 1 of 1 : SP_2019_NA0010_129_9_20190307_00001.jpg

LM Start	1.49	Rating **	M	Issue No.	9
LM End	1.49	Issue Type +	Ma	Location *	LS
Category	Earthen Levee			GPS Latitude/Longitude	
				Start	End
Item	Slope Stability			37.202748 °	37.202748 °
				-120.728182 °	-120.728182 °
DWR ID	DWR_NA0010_11_f_2017_9				
Comment Code					
S2 : Repair the levee slope damaged by foot traffic and prevent access where possible.					
Inspector Comment

Looking northwest at landside slope.

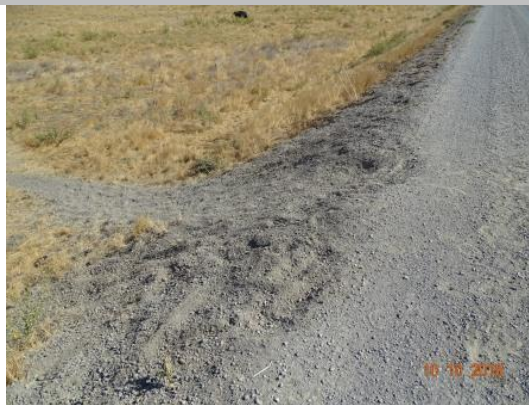
Photo 1 of 2 : SP_2019_NA0010_129_12_20190307_00006.jpg

LM Start	2.46	Rating **	M	Issue No.	12
LM End	2.46	Issue Type +	Ma	Location *	LS
Category	Earthen Levee			GPS Latitude/Longitude	
				Start	End
Item	Slope Stability			37.202712 °	37.202712 °
				-120.710633 °	-120.710633 °
DWR ID	DWR_NA0010_11_f_2018_12				
Comment Code					
S2 : Repair the levee slope damaged by foot traffic and prevent access where possible.					
Inspector Comment					
Damage is from livestock to both landside and waterside slopes.

View of landside slope. (Fall 2018)

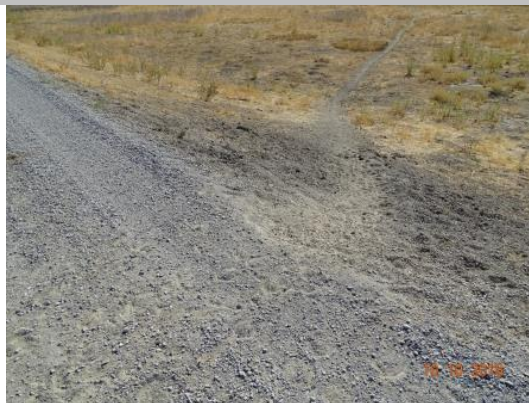
Photo 2 of 2 : SP_2019_NA0010_129_12_20190307_00007.jpg

LM Start	2.46	Rating **	M	Issue No.	12 (cont)	
LM End	2.46	Issue Type +	Ma	Location *	LS	
Category	Earthen Levee			GPS Latitude/Longitude		
				Start		End
Item	Slope Stability			37.202712 °		37.202712 °
				-120.710633 °		-120.710633 °
DWR ID	DWR_NA0010_11_f_2018_12					
Comment Code						
S2 : Repair the levee slope damaged by foot traffic and prevent access where possible.						
Inspector Comment						
Damage is from livestock to both landside and waterside slopes.

View of waterside slope. (Fall 2018)

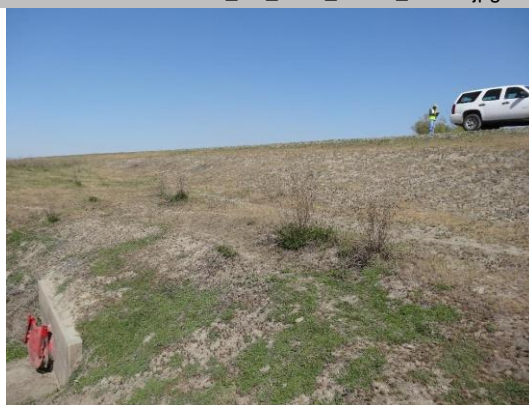
Photo 1 of 3 : UCIP_SP_2019_39523_62028.jpg

LM Start	3.04	Rating **	M	Issue No.	23
LM End	3.04	Issue Type +	Ma	Location *	
Category	Supplemental			GPS Latitude/Longitude	
				Start	End
Item	DWR UCIP LMA Responsibility			37.202494 °	37.202494 °
				-120.700153 °	-120.700153 °
DWR ID	19852				
Comment Code					
Inspector Comment					
FS_ID:39523					
DS_ID:19852					
EP_NO: N/A					
Repair Type: Non-Urgent					
Crossing Status: Found					
UCIP Comments: 04/18/2014 Need to contact owner. Recommend clearing sediment deposit inside pipe. (DWR UCIP - O. Magana)					
FIELD_STRUCT_DESC: 24-inch corrugated metal gravity drainage pipe through the levee, 15 feet below the crown. Flap gate on the waterside (WS) end. [Additional Reference(s): DWR Levee Log, 2002. USACE San Joaquin O&M Manual 601.1, 1967, (HLM 3.04)].					
FS Date: 4/18/2014

Overview of waterward side--flap gate, concrete headwall and apron visible on levee toe.
