**Flood Control Project Maintenance
Levee Inspections**
LMA District Cover Sheet
Spring 2019 Levee Inspection Results

Lower San Joaquin Levee District

Spring 2019 Levee Inspection Results

Waterway			Bank	Unit Miles
Unit No. 01 San Joaquin River			Right	22.52
	Spring (March - May)	Summer (June - August)	(September - November) Fall	Winter (December - February)
Unit Maintenance Rating (Fall Only)				
Date of Inspection	3/26/2019 - 3/26/2019			
DWR Inspector	Corey Fujitani			
Accompanied By

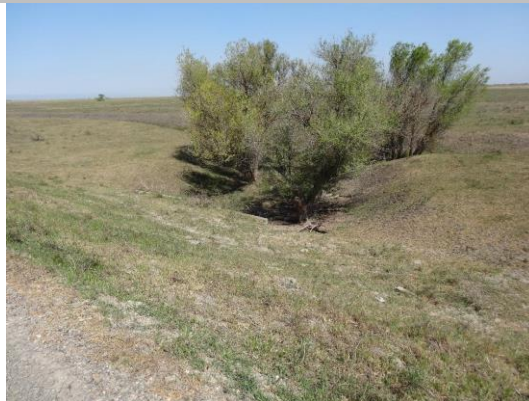
Photo 2 of 3 : UCIP_SP_2019_39523_62027.jpg

LM Start	3.04	Rating **	M	Issue No.	23 (cont)
LM End	3.04	Issue Type +	Ma	Location *	
Category	Supplemental			GPS Latitude/Longitude	
				Start	End
Item	DWR UCIP LMA Responsibility			37.202494 °	37.202494 °
				-120.700153 °	-120.700153 °
DWR ID	19852				
Comment Code					
Inspector Comment					
FS_ID:39523 DS_ID:19852 EP_NO: N/A Repair Type: Non-Urgent Crossing Status: Found UCIP Comments: 04/18/2014 Need to contact owner. Recommend clearing sediment deposit inside pipe. (DWR UCIP - O. Magana) FIELD_STRUCT_DESC: 24-inch corrugated metal gravity drainage pipe through the levee, 15 feet below the crown. Flap gate on the waterside (WS) end. [Additional Reference(s): DWR Levee Log, 2002. USACE San Joaquin O&M Manual 601.1, 1967, (HLM 3.04)]. FS Date: 4/18/2014

View of landward side.

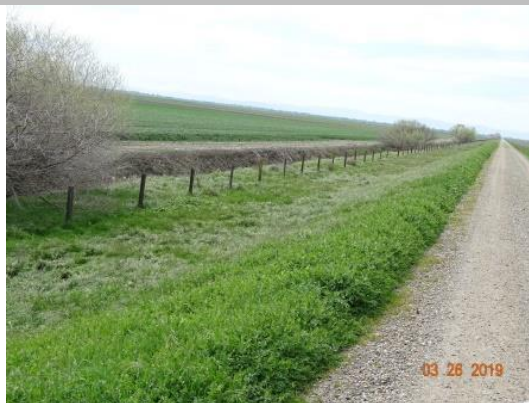
Photo 1 of 1 : SP_2019_NA0010_130_12_20190419_00026.jpg

LM Start	0.01	Rating **	M	Issue No.	12
LM End	2.84	Issue Type +	Ma	Location *	LS
Category	Earthen Levee			GPS Latitude/Longitude	
				Start	End
Item	Vegetation			37.200939 °	37.200921 °
				-120.755024 °	-120.703827 °
DWR ID	DWR_NA0010_12_f_2018_12				
Comment Code					
V1 : Control annual grass and weeds on the levee slopes and easements.					
Inspector Comment

View of landside slope looking downstream. (Spring 2019)

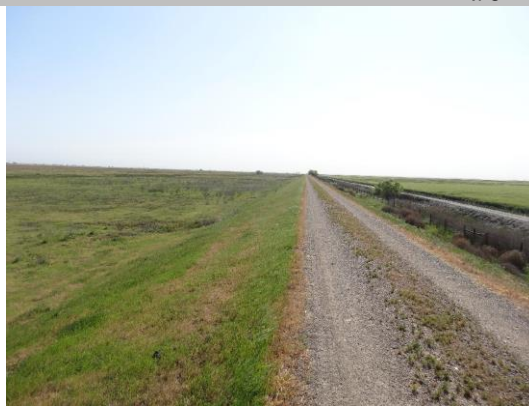
Photo 1 of 3 : UCIP_SP_2019_36704_66647.jpg

Comment Code						
Inspector Comment						
FS_ID:36704						
DS_ID:19855						
EP_NO: N/A						
Repair Type: Non-Urgent						
Crossing Status: Found						
UCIP Comments: 04/18/2014 Need to contact owner. Dense vegetation limits the inspector's visibility to identify signs of pipe failure (leaks) along the waterward slope. Recommend removing vegetation along pipe alignment to conduct proper inspection of structure. (DWR UCIP - O. Magana)						
FIELD_STRUCT_DESC: 24-inch corrugated metal gravity drainage pipe through the levee, 10.5 feet below the crown. Flap gate on the waterside (WS) end. [Additional Reference(s): DWR Levee Log, 2002. USACE San Joaquin O&M Manual 601.1, 1967, (HLM 0.39)].						
FS Date: 4/18/2014

View of waterward side.

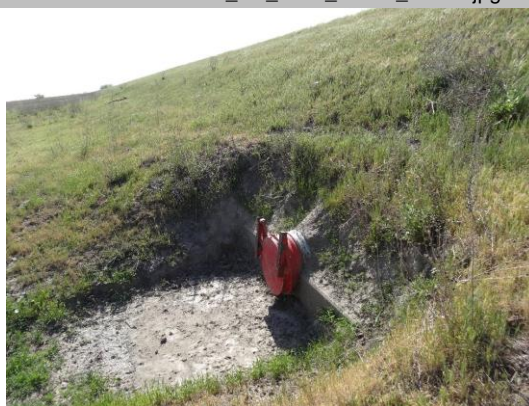
Photo 2 of 3 : UCIP_SP_2019_36704_66649.jpg

Comment Code						
Inspector Comment						
FS_ID:36704 DS_ID:19855 EP_NO: N/A Repair Type: Non-Urgent Crossing Status: Found UCIP Comments: 04/18/2014 Need to contact owner. Dense vegetation limits the inspector's visibility to identify signs of pipe failure (leaks) along the waterward slope. Recommend removing vegetation along pipe alignment to conduct proper inspection of structure. (DWR UCIP - O. Magana) FIELD_STRUCT_DESC: 24-inch corrugated metal gravity drainage pipe through the levee, 10.5 feet below the crown. Flap gate on the waterside (WS) end. [Additional Reference(s): DWR Levee Log, 2002. USACE San Joaquin O&M Manual 601.1, 1967, (HLM 0.39)]. FS Date: 4/18/2014

Concrete headwall and flap gate visible on waterward side.

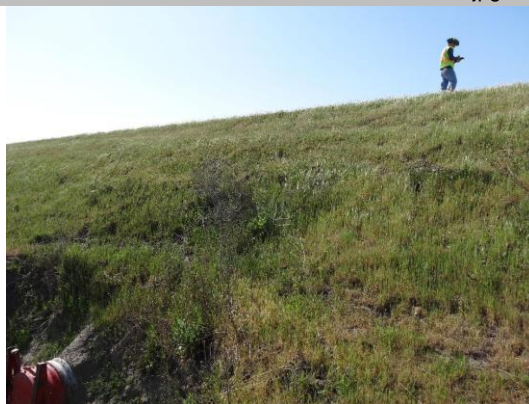
Photo 3 of 3 : UCIP_SP_2019_36704_66648.jpg

View of waterward side--medium grass throughout slope.

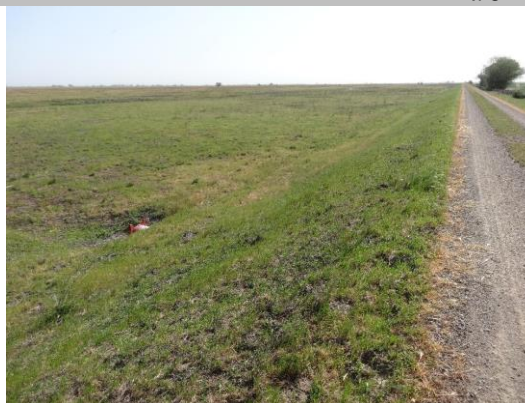
Photo 1 of 3 : UCIP_SP_2019_39889_62048.jpg

LM Start	1.06	Rating **	M	Issue No.	16
LM End	1.06	Issue Type +	Ma	Location *	
Category	Supplemental			GPS Latitude/Longitude	
				Start	End
Item	DWR UCIP LMA Responsibility			37.200922 °	37.200922 °
				-120.736012 °	-120.736012 °
DWR ID	19856				
Comment Code					
Inspector Comment					
FS_ID:39889					
DS_ID:19856					
EP_NO: N/A					
Repair Type: Non-Urgent					
Crossing Status: Found					
UCIP Comments: 04/18/2014 Need to contact owner. Recommend clearing sediment deposit inside pipe. (DWR UCIP - O. Magana)					
FIELD_STRUCT_DESC: 24-inch corrugated metal gravity drainage pipe through the levee, 10.5 feet below the crown. Flap gate on the waterside (WS) end. [Additional Reference(s): DWR Levee Log, 2002. USACE San Joaquin O&M Manual 601.1, 1967, (HLM 1.06)].					
FS Date: 4/18/2014

View of waterward side.

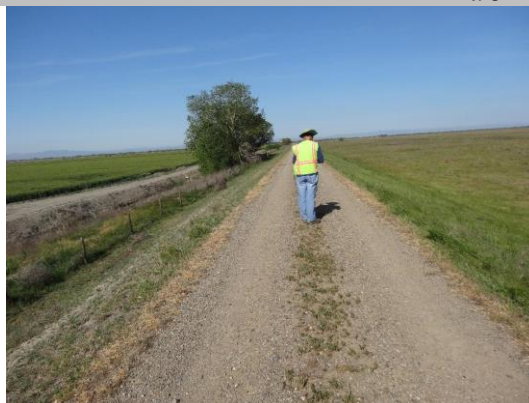
Photo 1 of 3 : UCIP_SP_2019_36705_66654.jpg

Comment Code					
Inspector Comment					
FS_ID:36705 DS_ID:19857 EP_NO: N/A Repair Type: Non-Urgent Crossing Status: Found UCIP Comments: 04/18/2014 Landward side not accessible due to dense vegetation and fence. Concrete headwall and flap gate under water therefore not able to evaluate condition. Will need to coordinate with owner to evaluate condition of crossing on waterward side and obtain access to evaluate landward side. (DWR UCIP - O. Magana) FIELD_STRUCT_DESC: 24-inch corrugated metal gravity drainage pipe through the levee, 17.4 feet below the crown. Flap gate on the waterside (WS) end. [Additional Reference(s): DWR Levee Log, 2002. USACE San Joaquin O&M Manual 601.1, 1967, (HLM 1.27)]. FS Date: 4/18/2014

Overview of levee crown at crossing.

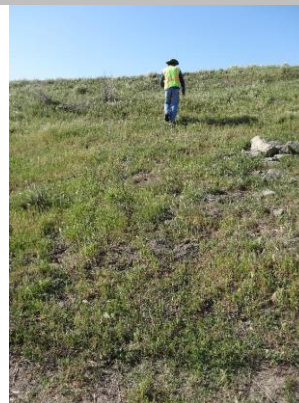
Photo 2 of 3 : UCIP_SP_2019_36705_66652.jpg

Comment Code						
Inspector Comment						
FS_ID:36705						
DS_ID:19857						
EP_NO: N/A						
Repair Type: Non-Urgent						
Crossing Status: Found						
UCIP Comments: 04/18/2014 Landward side not accessible due to dense vegetation and fence. Concrete headwall and flap gate under water therefore not able to evaluate condition. Will need to coordinate with owner to evaluate condition of crossing on waterward side and obtain access to evaluate landward side. (DWR UCIP - O. Magana)						
FIELD_STRUCT_DESC: 24-inch corrugated metal gravity drainage pipe through the levee, 17.4 feet below the crown. Flap gate on the waterside (WS) end. [Additional Reference(s): DWR Levee Log, 2002. USACE San Joaquin O&M Manual 601.1, 1967, (HLM 1.27)].						
FS Date: 4/18/2014

View of waterward slope.

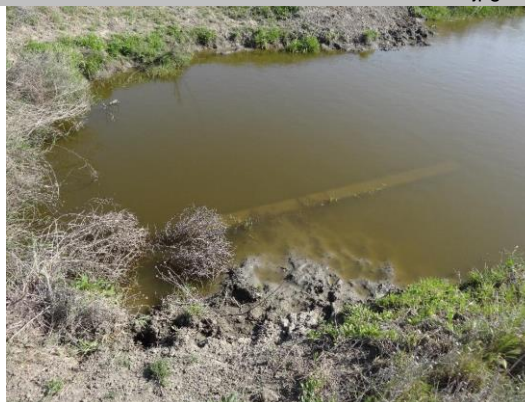
Photo 3 of 3 : UCIP_SP_2019_36705_66653.jpg

View of concrete wall underwater.

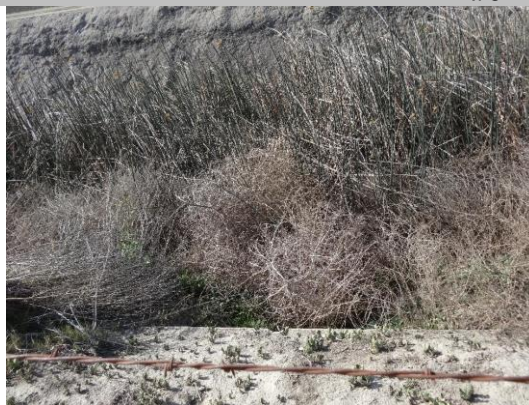
Photo 3 of 3 : UCIP_SP_2019_39506_62062.jpg

LM Start	2.16	Rating **	M	Issue No.	19 (cont)	
LM End	2.16	Issue Type +	Ma	Location *		
Category	Supplemental			GPS Latitude/Longitude		
				Start	End	
Item	DWR UCIP LMA Responsibility			37.200908 °	37.200908 °	
				-120.716118 °	-120.716118 °	
DWR ID	19859					
Comment Code						
Inspector Comment						
FS_ID:39506 DS_ID:19859 EP_NO: N/A Repair Type: Non-Urgent Crossing Status: Found UCIP Comments: 04/18/2014 Need to contact owner. Recommend clearing vegetation from landward side--headwall blocked. (DWR UCIP - O. Magana) FIELD_STRUCT_DESC: 24-inch corrugated metal gravity drainage pipe through the levee, 14.4 feet below the crown. Flap gate on the waterside (WS) end. [Additional Reference(s): DWR Levee Log, 2002. USACE San Joaquin O&M Manual 601.1, 1967, (HLM 2.16)]. FS Date: 4/18/2014

Dense vegetation on landward side--limited access due to fence along landward side.

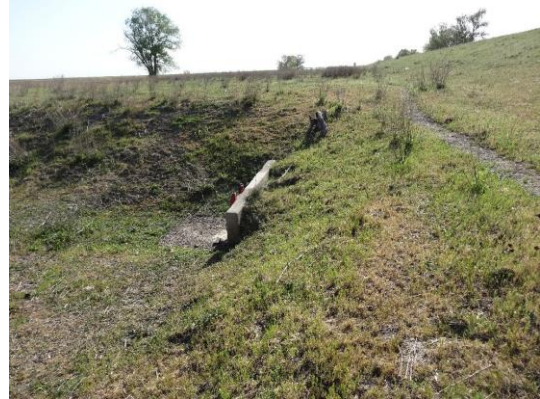
Photo 3 of 3 : UCIP_SP_2019_46786_62072.jpg

Comment Code						
Inspector Comment						
FS_ID:46786 DS_ID:19861 EP_NO: N/A Repair Type: Non-Urgent Crossing Status: Found UCIP Comments: 11/09/2015 DWR Inspection section confirmed issue has been addressed. Need to coordinate with LMA to determine additional details for extent of repair. 04/18/2014 Soil missing behind concrete headwall on waterward side. Unable to determine if missing soil is due to sink holes, rodent activity, or due to erosion. Headwall appears to be leaning slightly forward. Reason why this crossing was labelled urgent was due to the uncertainty of damage to concrete headwall and reason for soil missing behind concrete. Need to coordinate with LMA to determine more information about repair at this location. (DWR UCIP - O. Magana) FIELD_STRUCT_DESC: 24-inch corrugated metal gravity drainage pipe through the levee, 2 feet below the crown. Flap gate on the waterside (WS) end. [Additional Reference(s): DWR Levee Log, 2002. USACE San Joaquin O&M Manual 601.1, 1967, (HLM 3.00)]. FS Date: 11/10/2015 9:29:00 AM

Side view of concrete headwall which appears to be slightly slanted forward--missing soil behind headwall.

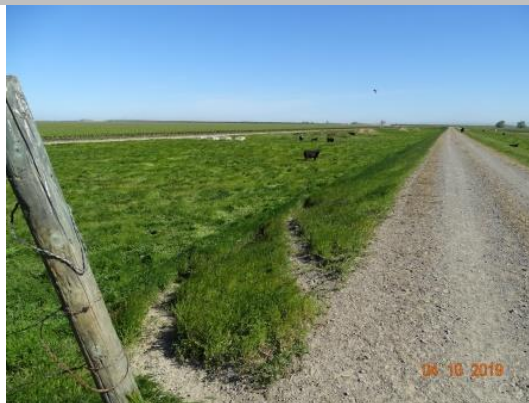
Photo 1 of 1 : SP_2019_NA0010_131_4_20190426_00020.jpg

LM Start	0.02	Rating **	M	Issue No.	4
LM End	1.26	Issue Type +	Ma	Location *	LS
Category	Earthen Levee			GPS Latitude/Longitude	
				Start	End
Item	Vegetation			37.033971 °	37.046304 °
				-120.442011 °	-120.428097 °
DWR ID	DWR_NA0010_13_s_2019_4				
Comment Code					
V1 : Control annual grass and weeds on the levee slopes and easements.					
Inspector Comment

View of landside slope looking upstream. (Spring 2019)

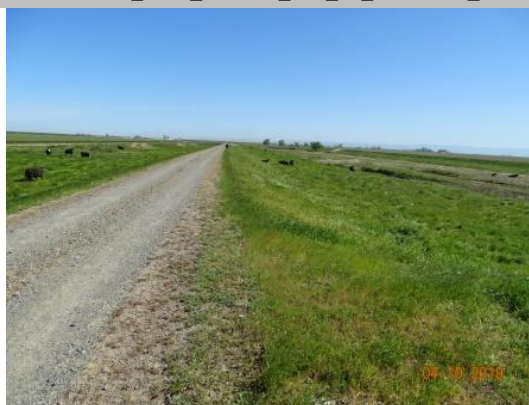
Photo 1 of 1 : SP_2019_NA0010_131_10_20190426_00019.jpg

LM Start	0.02	Rating **	M	Issue No.	10
LM End	1.26	Issue Type +	Ma	Location *	WS
Category	Earthen Levee			GPS Latitude/Longitude	
				Start	End
Item	Vegetation			37.033971 °	37.046304 °
				-120.442011 °	-120.428097 °
DWR ID	DWR_NA0010_13_s_2019_10				
Comment Code					
V1 : Control annual grass and weeds on the levee slopes and easements.					
Inspector Comment

View of waterside slope looking upstream. (Spring 2019)

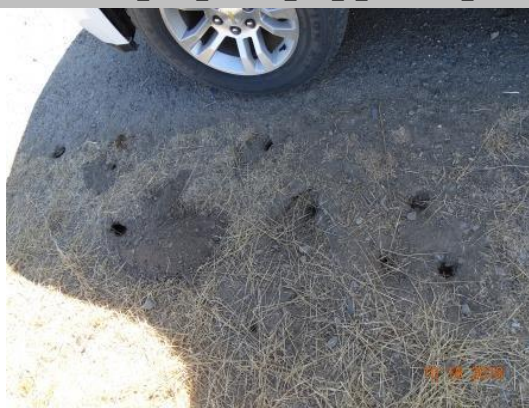
Photo 1 of 1 : SP_2019_NA0010_131_9_20190307_00012.jpg

LM Start	0.90	Rating **	M	Issue No.	9
LM End	0.90	Issue Type +	Ma	Location *	LS
Category	Earthen Levee			GPS Latitude/Longitude	
				Start	End
Item	Animal Control			37.044778 °	37.044778 °
				-120.434198 °	-120.434198 °
DWR ID	DWR_NA0010_13_f_2018_9				
Comment Code					
A3 : No rodents visible, but rodent burrows visible; need to backfill and compact or grout burrows.					
Inspector Comment

View of several rodent burrows in landside shoulder. (Fall 2018)

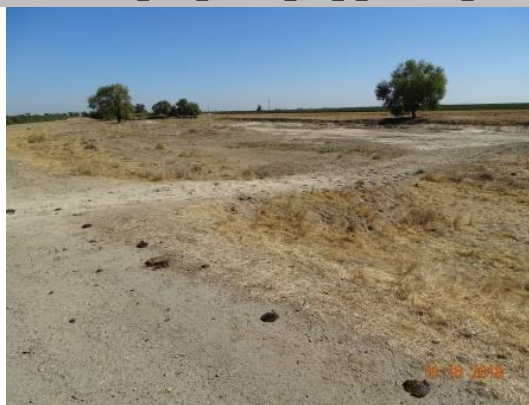
Photo 1 of 3 : SP_2019_NA0010_131_5_20190307_00002.jpg

LM Start	0.91	Rating **	M	Issue No.	5
LM End	0.91	Issue Type +	En	Location *	WS
Category	Earthen Levee			GPS Latitude/Longitude	
				Start	End
Item	Encroachments			37.044855 °	37.044855 °
				-120.434106 °	-120.434106 °
DWR ID	DWR_NA0010_13_s_2014_5				
Comment Code					
RA : Ramp					
Inspector Comment					
There is an unauthorized ramp on waterside slope.

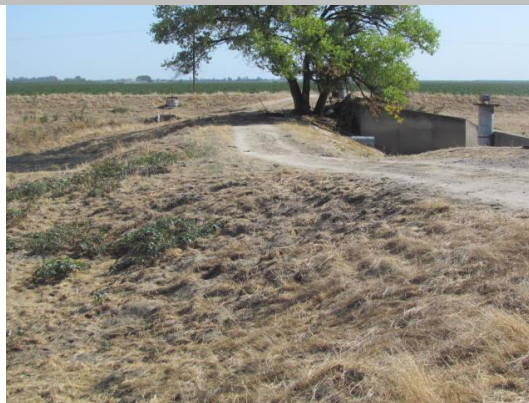
Photo 1 of 6 : SP_2019_NA0010_131_6_20190307_00005.jpg

LM Start	1.14	Rating **	U	Issue No.	6
LM End	1.14	Issue Type +	En	Location *	WS
Category	Earthen Levee			GPS Latitude/Longitude	
				Start	End
Item	Encroachments			37.045541 °	37.045541 °
				-120.430014 °	-120.430014 °
DWR ID	DWR_NA0010_13_f_2015_6				
Comment Code					
WL : Wall					
Inspector Comment					
Sand dam may have been blown out due to high flows in 2017 but has been restored.

Looking overview of sand dam.

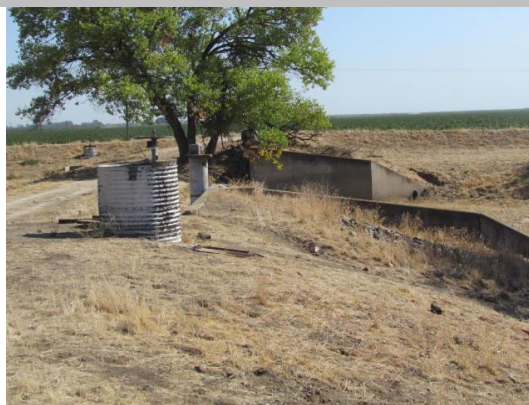
Photo 3 of 6 : SP_2019_NA0010_131_6_20190307_00007.jpg

Looking south at downstream side of structure.

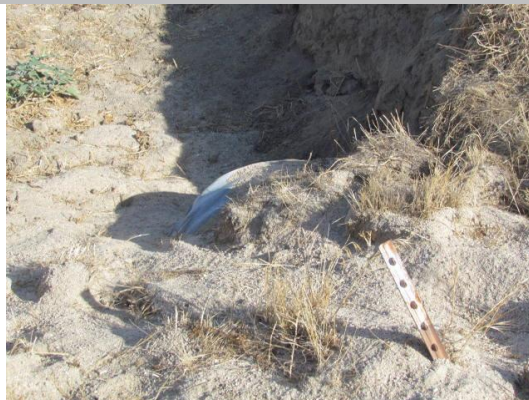
Photo 4 of 6 : SP_2019_NA0010_131_6_20190307_00008.jpg

Looking at corrugated pipe on north end on upstream side of structure.

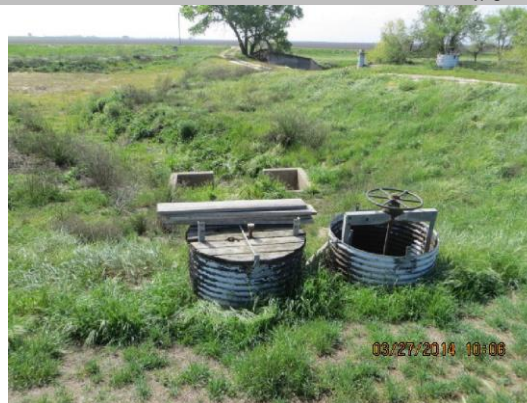
Photo 1 of 3 : UCIP_SP_2019_39877_59385.jpg

Comment Code					
Inspector Comment					
FS_ID:39877					
DS_ID:19727					
EP_NO: N/A					
Repair Type: Non-Urgent					
Crossing Status: Found					
UCIP Comments: 03/27/2014 Appears abandoned and if so should be done so properly. Pipe filled with soil on WS at outlet. Actuator missing from slide gate on WS shoulder. (DWR UCIP - W. Wylie)					
FIELD_STRUCT_DESC: [Rounder Irrigation Structure] 1 of 2: 36-inch corrugated metal gravity drainage pipe through the levee, 12.3 feet below the crown. Slide gate in a 48-inch corrugated metal pipe (CMP) riser on the waterside (WS) slope. 6-foot by 12-foot concrete distribution box on the landside (LS). 7-foot by 14-foot concrete outlet structure on the WS toe. [Additional Reference(s): DWR Levee Log, 2002. USACE San Joaquin O&M Manual 601.1, 1967, (HLM 1.14)].					
FS Date: 3/27/2014

Slide gate in CMP riser on WS shoulder.

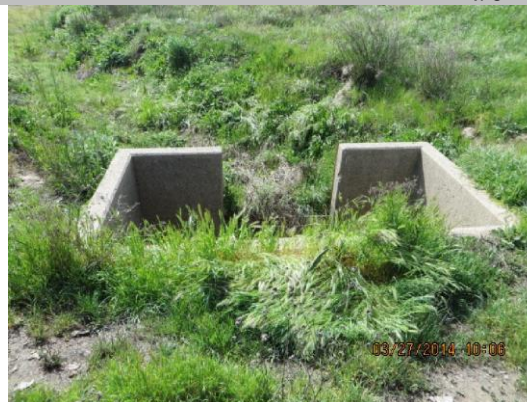
Photo 2 of 3 : UCIP_SP_2019_39877_59384.jpg

Concrete box on WS toe.

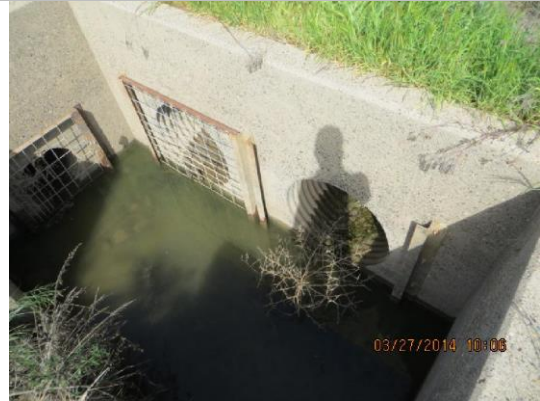
Photo 3 of 3 : UCIP_SP_2019_39877_59389.jpg

Comment Code						
Inspector Comment						
FS_ID:39877 DS_ID:19727 EP_NO: N/A Repair Type: Non-Urgent Crossing Status: Found UCIP Comments: 03/27/2014 Appears abandoned and if so should be done so properly. Pipe filled with soil on WS at outlet. Actuator missing from slide gate on WS shoulder. (DWR UCIP - W. Wylie) FIELD_STRUCT_DESC: [Rounder Irrigation Structure] 1 of 2: 36-inch corrugated metal gravity drainage pipe through the levee, 12.3 feet below the crown. Slide gate in a 48-inch corrugated metal pipe (CMP) riser on the waterside (WS) slope. 6-foot by 12-foot concrete distribution box on the landside (LS). 7-foot by 14-foot concrete outlet structure on the WS toe. [Additional Reference(s): DWR Levee Log, 2002. USACE San Joaquin O&M Manual 601.1, 1967, (HLM 1.14)]. FS Date: 3/27/2014

Concrete box on WS toe.

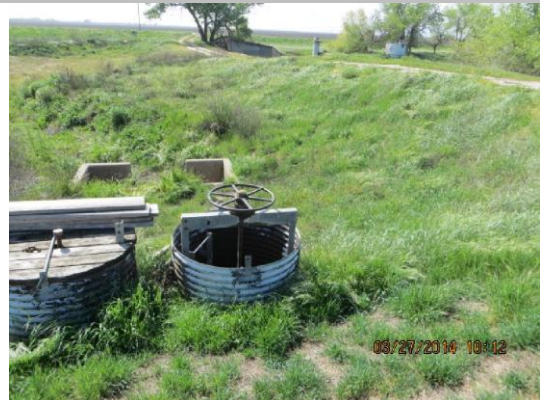
Photo 1 of 3 : UCIP_SP_2019_39524_59390.jpg

Comment Code					
Inspector Comment					
FS_ID:39524 DS_ID:19908 EP_NO: N/A Repair Type: Non-Urgent Crossing Status: Found UCIP Comments: 03/27/2014 No lid on riser at WS shoulder could be safety issue. (DWR UCIP - W. Wylie) FIELD_STRUCT_DESC: [Rounder Irrigation Structure] 2 of 2: 36-inch corrugated metal gravity drainage pipe through the levee, 12.3 feet below the crown. Slide gate in a 48-inch corrugated metal pipe (CMP) riser on the waterside (WS) slope. 6-foot by 12-foot concrete distribution box on the landside (LS). 7-foot by 14-foot concrete outlet structure on the WS toe. [Additional Reference(s): DWR Levee Log, 2002. USACE San Joaquin O&M Manual 601.1, 1967, (HLM 1.14)]. FS Date: 3/27/2014

Slide gate in CMP riser without lid on WS shoulder.

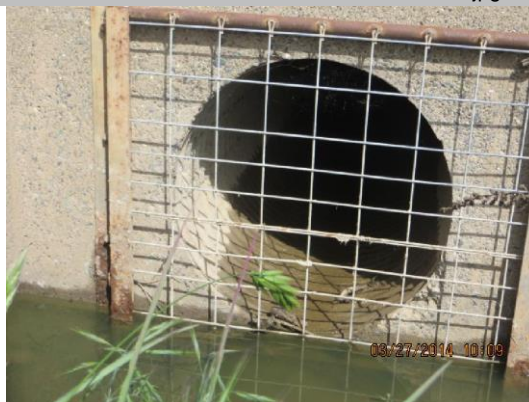
Photo 3 of 3 : UCIP_SP_2019_39524_59391.jpg

Pipe at outlet on WS toe.

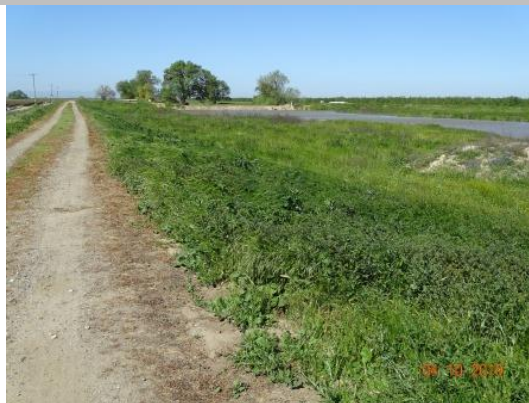
Photo 1 of 1 : SP_2019_NA0010_132_7_20190426_00010.jpg

LM Start	0.01	Rating **	U	Issue No.	7
LM End	1.26	Issue Type +	Ma	Location *	WS
Category	Earthen Levee			GPS Latitude/Longitude	
				Start	End
Item	Vegetation			37.032442 °	37.045405 °
				-120.441231 °	-120.427738 °
DWR ID	DWR_NA0010_14_s_2019_7				
Comment Code					
V1 : Control annual grass and weeds on the levee slopes and easements.					
Inspector Comment

View of waterside slope looking downstream. (Spring 2019)

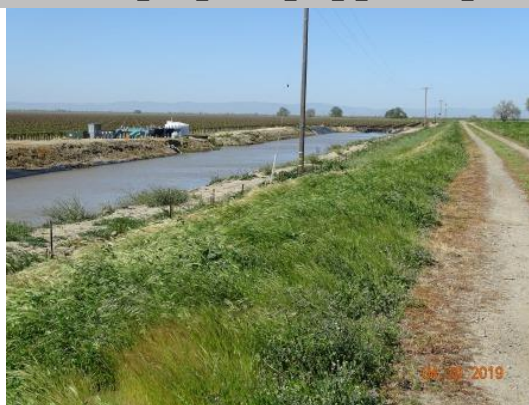
Photo 1 of 1 : SP_2019_NA0010_132_8_20190426_00011.jpg

LM Start	0.01	Rating **	U	Issue No.	8
LM End	1.26	Issue Type +	Ma	Location *	LS
Category	Earthen Levee			GPS Latitude/Longitude	
				Start	End
Item	Vegetation			37.032447 °	37.045405 °
				-120.441229 °	-120.427738 °
DWR ID	DWR_NA0010_14_s_2019_8				
Comment Code					
V1 : Control annual grass and weeds on the levee slopes and easements.					
Inspector Comment

View of landside slope looking downstream. (Spring 2019)

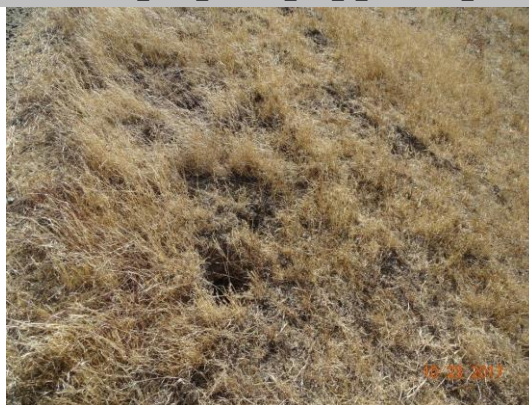
Photo 1 of 1 : SP_2019_NA0010_132_5_20190307_00002.jpg

LM Start	0.25	Rating **	M	Issue No.	5
LM End	0.25	Issue Type +	Ma	Location *	LS
Category	Earthen Levee			GPS Latitude/Longitude	
				Start	End
Item	Animal Control			37.035841 °	37.035841 °
				-120.439795 °	-120.439795 °
DWR ID	DWR_NA0010_14_f_2017_5				
Comment Code					
A3 : No rodents visible, but rodent burrows visible; need to backfill and compact or grout burrows.					
Inspector Comment

Looking at the landside slope.

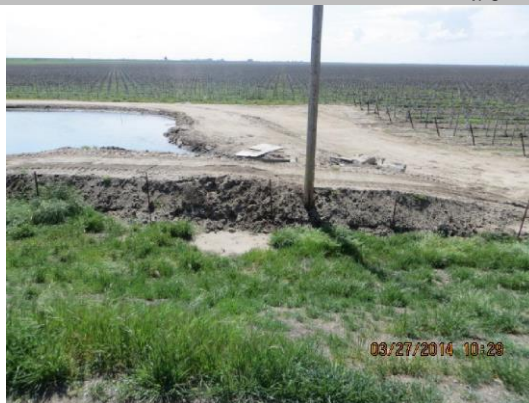
Photo 3 of 3 : UCIP_SP_2019_39526_59397.jpg

Comment Code						
Inspector Comment						
FS_ID:39526 DS_ID:19909 EP_NO: N/A Repair Type: Non-Urgent Crossing Status: Found UCIP Comments: 03/27/2014 Lid should be installed on CMP riser on WS slope, could be a safety hazard. Also dense vegetation limits the inspector's visibility to identify signs of pipe failure (leaks) along the slope. Recommend removing vegetation along pipe alignment to conduct proper inspection of structure. (DWR UCIP - O. Magana) FIELD_STRUCT_DESC: [Rounder Irrigation Structure] 36-inch corrugated metal gravity irrigation pipe through the levee, 10 feet below the crown. Slide gate in a 48-inch corrugated metal pipe (CMP) riser on the waterside (WS) slope. 6-foot by 7-foot concrete distribution box at the WS toe. Slots for wooden flashboards on the WS of the box. 7-foot by 9-foot concrete distribution box on the landside (LS), 20 feet from the toe. [Additional Reference(s): DWR Levee Log, 2002. USACE San Joaquin O&M Manual 601.1, 1967, (HLM 1.15)]. FS Date: 3/27/2014

Concrete distribution box visible next to power pole off LS toe.

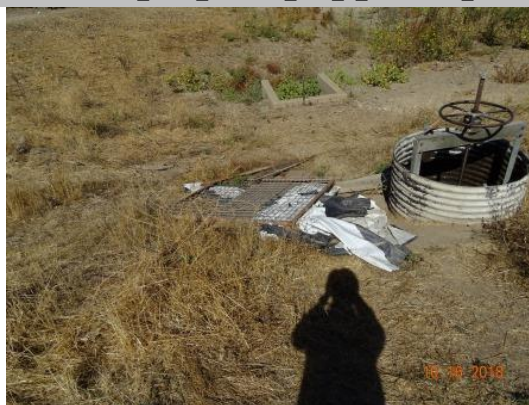
Photo 1 of 1 : SP_2019_NA0010_132_3_20190307_00001.jpg

LM Start	1.15	Rating **	M	Issue No.	3
LM End	1.15	Issue Type +	En	Location *	WS
Category	Earthen Levee			GPS Latitude/Longitude	
				Start	End
Item	Encroachments			37.044943 °	37.044943 °
				-120.429624 °	-120.429624 °
DWR ID	DWR_NA0010_14_f_2018_3				
Comment Code					
GA : Garbage					
Inspector Comment					
Garbage was left on the waterside slope.

View of garbage left on waterside slope. (Fall 2018)

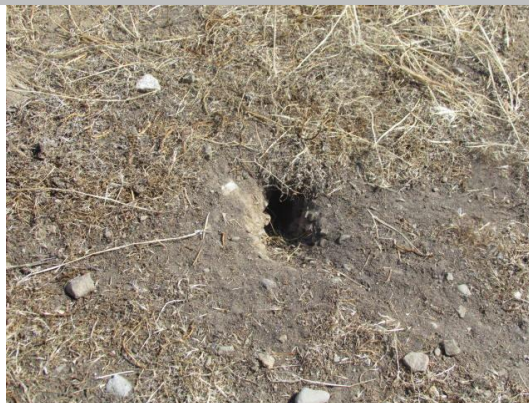
Photo 1 of 1 : SP_2019_NA0010_132_79_20190307_00003.jpg

LM Start	1.24	Rating **	M	Issue No.	79
LM End	1.24	Issue Type +	Ma	Location *	LS
Category	Earthen Levee			GPS Latitude/Longitude	
				Start	End
Item	Animal Control			37.045343 °	37.045343 °
				-120.428007 °	-120.428007 °
DWR ID	DWR_NA0010_14_s_2015_79				
Comment Code					
A3 : No rodents visible, but rodent burrows visible; need to backfill and compact or grout burrows.					
Inspector Comment					
Several rodent holes are noted on the landside at this location.

Looking at typical view of rodent holes on landward slope.

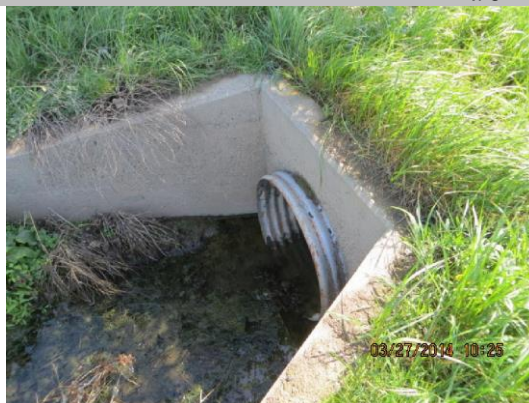
Photo 1 of 3 : UCIP_SP_2019_32828_59402.jpg

LM Start	1.26	Rating **	A/W	Issue No.	81
LM End	1.26	Issue Type +	Ma	Location *	
Category	Supplemental			GPS Latitude/Longitude	
				Start	End
Item	DWR UCIP LMA Responsibility			37.045383 °	37.045383 °
				-120.427754 °	-120.427754 °
DWR ID	19910				
Comment Code					
Inspector Comment					
FS_ID:32828 DS_ID:19910 EP_NO: N/A Repair Type: No Action Needed Crossing Status: Found UCIP Comments: FIELD_STRUCT_DESC: 36-inch corrugated metal gravity drainage pipe through the levee, 9 feet below the crown. Slide gate in a 42-inch corrugated metal pipe (CMP) riser on the waterside (WS) slope. Concrete U-shaped headwall on the WS end. Pipe terminates into a concrete ditch on the landside (LS). [Additional Reference(s): DWR Levee Log, 2002. USACE San Joaquin O&M Manual 601.1, 1967, (HLM 1.26)]. FS Date: 3/27/2014

Concrete U-shaped headwall on Ws toe.

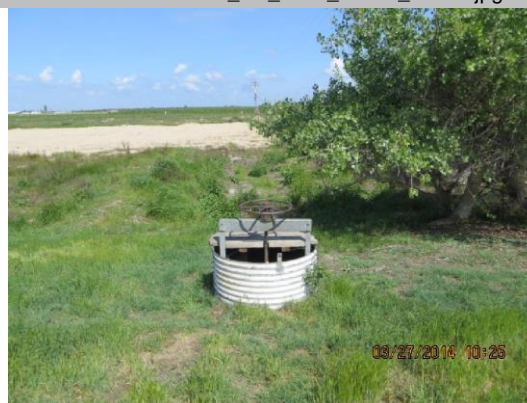
Photo 2 of 3 : UCIP_SP_2019_32828_59401.jpg

slidegate in CMP riser on WS slope.

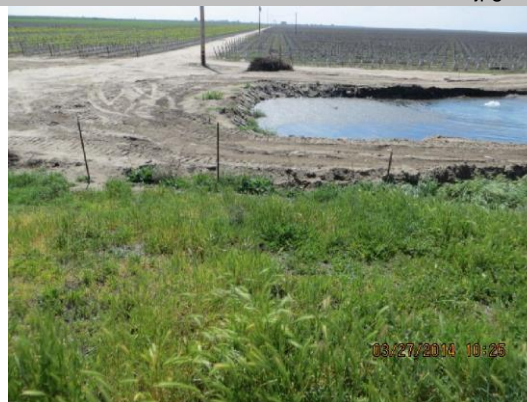
Photo 3 of 3 : UCIP_SP_2019_32828_59400.jpg

Inlet assumed to be within irrigation structure off LS toe.

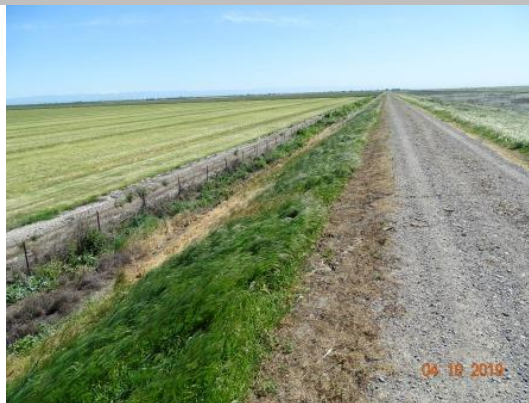
Photo 1 of 1 : SP_2019_NA0010_133_5_20190426_00015.jpg

LM Start	0.01	Rating **	M	Issue No.	5
LM End	0.15	Issue Type +	Ma	Location *	LS
Category	Earthen Levee			GPS Latitude/Longitude	
				Start	End
Item	Vegetation			36.996556 °	36.996552 °
				-120.410229 °	-120.407748 °
DWR ID	DWR_NA0010_15_f_2018_5				
Comment Code					
V1 : Control annual grass and weeds on the levee slopes and easements.					
Inspector Comment

View of landside slope. (Spring 2019)

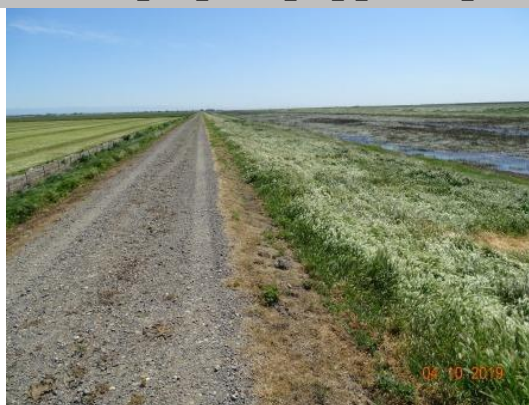
Photo 1 of 1 : SP_2019_NA0010_133_7_20190426_00014.jpg

LM Start	0.02	Rating **	M	Issue No.	7
LM End	0.82	Issue Type +	Ma	Location *	WS
Category	Earthen Levee			GPS Latitude/Longitude	
				Start	End
Item	Vegetation			36.996550 °	36.996551 °
				-120.409977 °	-120.395523 °
DWR ID	DWR_NA0010_15_f_2018_7				
Comment Code					
V1 : Control annual grass and weeds on the levee slopes and easements.					
Inspector Comment

View of waterside slope looking upstream. (Spring 2019)

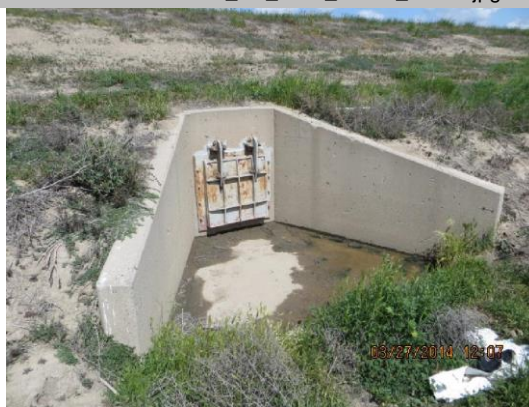
Photo 2 of 3 : UCIP_SP_2019_32838_59449.jpg

Flapgate on Concrete headwall at WS toe.

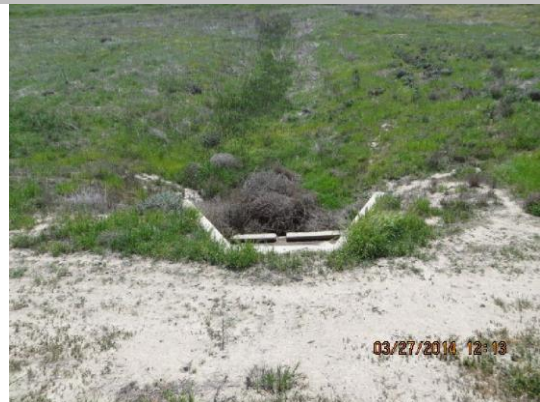
Photo 1 of 3 : UCIP_SP_2019_39527_59452.jpg

Comment Code						
Inspector Comment						
FS_ID:39527						
DS_ID:19912						
EP_NO: N/A						
Repair Type: Non-Urgent						
Crossing Status: Found						
UCIP Comments: 03/27/2014 Dense vegetation limits the inspector's visibility to identify signs of pipe failure (leaks) along the landward slope. Recommend removing vegetation along pipe alignment to conduct proper inspection of structure. (DWR UCIP - W. Wylie)						
FIELD_STRUCT_DESC: 30-inch by 30-inch square reinforced concrete box gravity drainage culvert through the levee, 8.5 feet below the crown. Flap gate on the waterside (WS) end. Concrete headwall on the landside (LS) end. Concrete U-shaped headwall on the WS end.						
[Additional Reference(s): DWR Levee Log, 2002. USACE San Joaquin O&M Manual 601.1, 1967, (HLM 1.01)].						
FS Date: 3/27/2014

Concrete headwall on WS toe.

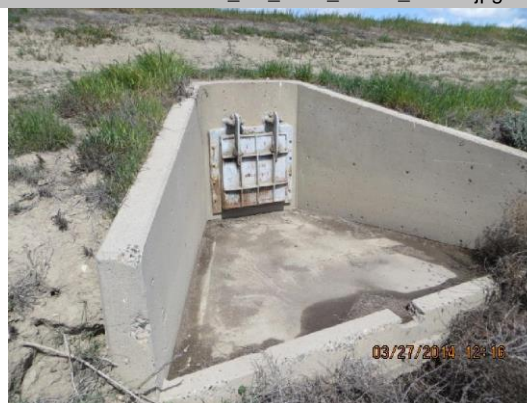
Photo 2 of 3 : UCIP_SP_2019_39527_59453.jpg

Comment Code						
Inspector Comment						
FS_ID:39527 DS_ID:19912 EP_NO: N/A Repair Type: Non-Urgent Crossing Status: Found UCIP Comments: 03/27/2014 Dense vegetation limits the inspector's visibility to identify signs of pipe failure (leaks) along the landward slope. Recommend removing vegetation along pipe alignment to conduct proper inspection of structure. (DWR UCIP - W. Wylie) FIELD_STRUCT_DESC: 30-inch by 30-inch square reinforced concrete box gravity drainage culvert through the levee, 8.5 feet below the crown. Flap gate on the waterside (WS) end. Concrete headwall on the landside (LS) end. Concrete U-shaped headwall on the WS end. [Additional Reference(s): DWR Levee Log, 2002. USACE San Joaquin O&M Manual 601.1, 1967, (HLM 1.01)]. FS Date: 3/27/2014

Flapgate on concrete headwall at WS toe.

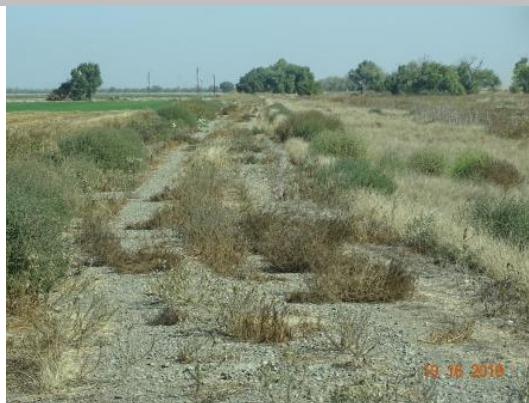
Photo 1 of 1 : SP_2019_NA0010_133_12_20190307_00004.jpg

LM Start	1.51	Rating **	M	Issue No.	12
LM End	2.02	Issue Type +	Ma	Location *	CR
Category	Earthen Levee			GPS Latitude/Longitude	
				Start	End
Item	Vegetation			36.996562 °	36.996586 °
				-120.383121 °	-120.373850 °
DWR ID	DWR_NA0010_15_f_2018_12				
Comment Code					
V9 : Keep the crown roadway free of vegetation.					
Inspector Comment					
Vegetation on levee crown should be removed.

View of moderate vegetation on levee crown. (Fall 2018)

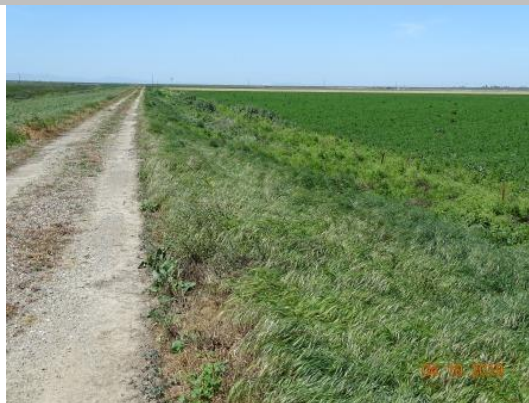
Photo 1 of 2 : SP_2019_NA0010_133_9_20190426_00016.jpg

LM Start	1.52	Rating **	U	Issue No.	9 (cont)
LM End	2.03	Issue Type +	Ma	Location *	LS

View of landside slope looking downstream. (Spring 2019)

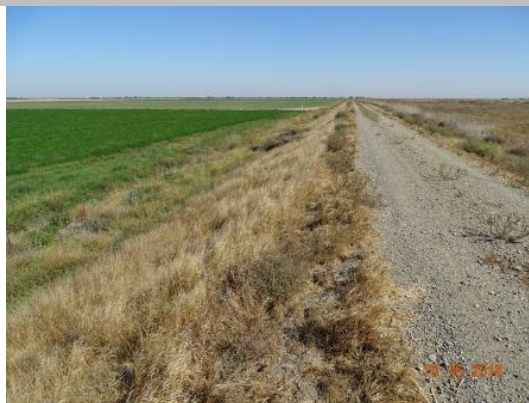
Photo 2 of 2 : SP_2019_NA0010_133_9_20190307_00002.jpg

View of heavy grass on landside slope and toe. (Fall 2018)

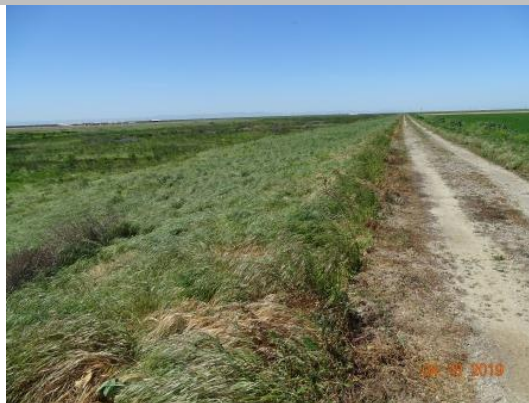
Photo 1 of 2 : SP_2019_NA0010_133_10_20190426_00017.jpg

LM Start	1.52	Rating **	U	Issue No.	10
LM End	2.03	Issue Type +	Ma	Location *	WS
Category	Earthen Levee			GPS Latitude/Longitude	
				Start	End
Item	Vegetation			36.996561 °	36.996587 °
				-120.382869 °	-120.373767 °
DWR ID	DWR_NA0010_15_f_2018_10				
Comment Code					
V1 : Control annual grass and weeds on the levee slopes and easements.					
Inspector Comment					
Heavy grass is located on the waterside slope.

View of waterside slope looking downstream. (Spring 2019)

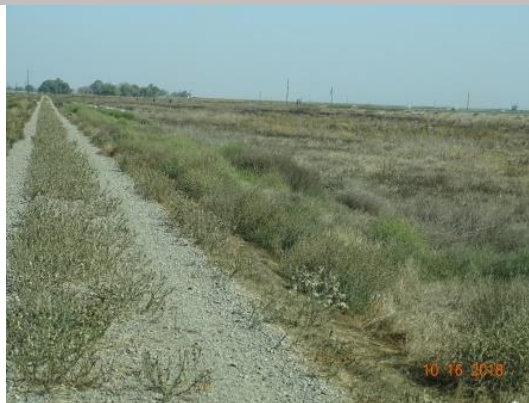
Photo 2 of 2 : SP_2019_NA0010_133_10_20190307_00003.jpg

LM Start	1.52	Rating **	U	Issue No.	10 (cont)	
LM End	2.03	Issue Type +	Ma	Location *	WS	
Category	Earthen Levee			GPS Latitude/Longitude		
				Start		End
Item	Vegetation			36.996561 °		36.996587 °
				-120.382869 °		-120.373767 °
DWR ID	DWR_NA0010_15_f_2018_10					
Comment Code						
V1 : Control annual grass and weeds on the levee slopes and easements.						
Inspector Comment						
Heavy grass is located on the waterside slope.

View of heavy vegetation on waterside slope. (Fall 2018)

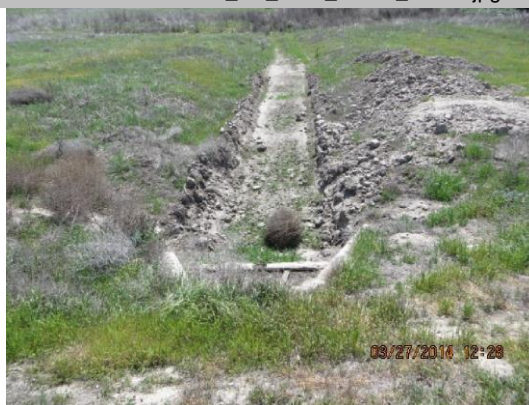
Photo 1 of 3 : UCIP_SP_2019_32840_59456.jpg

LM Start	1.53	Rating **	M	Issue No.	15	
LM End	1.53	Issue Type +	Ma	Location *		
Category	Supplemental			GPS Latitude/Longitude		
				Start		End
Item	DWR UCIP LMA Responsibility			36.996582 °		36.996582 °
				-120.382757 °		-120.382757 °
DWR ID	19913					
Comment Code						
Inspector Comment						
FS_ID:32840 DS_ID:19913 EP_NO: N/A Repair Type: Non-Urgent Crossing Status: Found UCIP Comments: 03/27/2014 Excessive vegetation at inlet on LS toe. (DWR UCIP - W. Wylie) FIELD_STRUCT_DESC: 30-inch by 30-inch square reinforced concrete box gravity drainage culvert through the levee, 8.9 feet below the crown. Flap gate on the waterside (WS) end. Concrete headwall on the landside (LS) end. Concrete U-shaped headwall on the WS end. [Additional Reference(s): DWR Levee Log, 2002. USACE San Joaquin O&M Manual 601.1, 1967, (HLM 1.53)]. FS Date: 3/27/2014

Concrete headwall on WS toe.

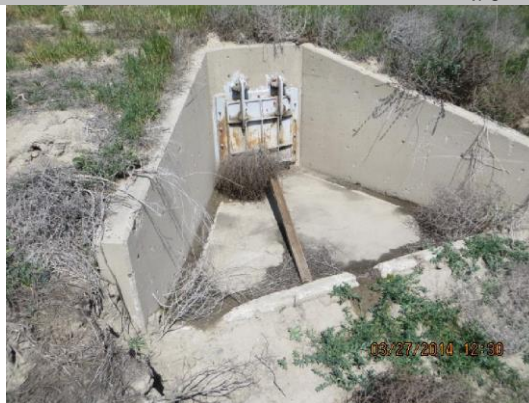
Photo 2 of 3 : UCIP_SP_2019_32840_59457.jpg

Flapgate on concrete headwall at WS toe.

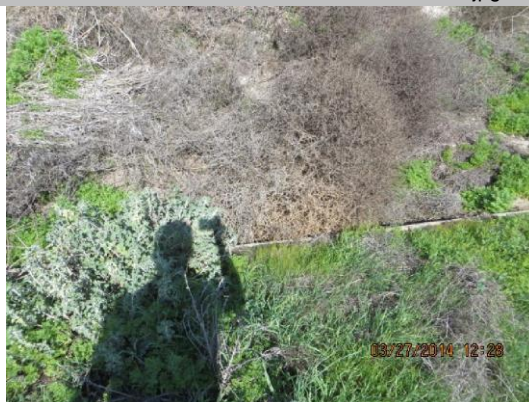
Photo 3 of 3 : UCIP_SP_2019_32840_59455.jpg

Concrete headwall on LS toe. Note excessive vegetation buildup.

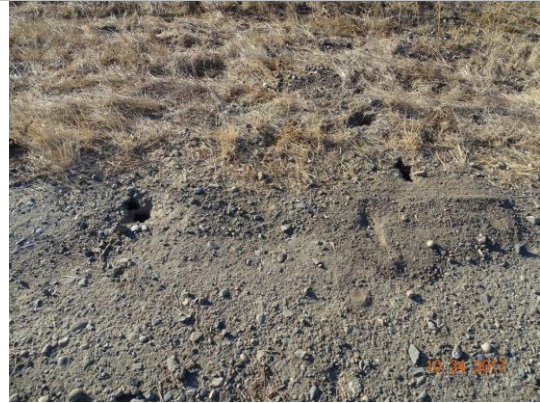
Photo 1 of 1 : SP_2019_NA0010_133_6_20190307_00001.jpg

LM Start	1.58	Rating **	M	Issue No.	6
LM End	2.01	Issue Type +	Ma	Location *	CR
Category	Earthen Levee			GPS Latitude/Longitude	
				Start	End
Item	Animal Control			36.996563 °	36.996578 °
				-120.381895 °	-120.374111 °
DWR ID	DWR_NA0010_15_f_2017_6				
Comment Code					
A3 : No rodents visible, but rodent burrows visible; need to backfill and compact or grout burrows.					
Inspector Comment

Representative picture of the crown.

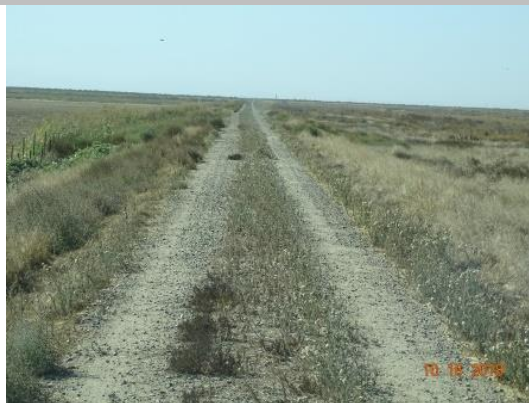
Photo 1 of 1 : SP_2019_NA0010_134_7_20190307_00006.jpg

LM Start	0.01	Rating **	M	Issue No.	7
LM End	1.41	Issue Type +	Ma	Location *	CR
Category	Earthen Levee			GPS Latitude/Longitude	
				Start	End
Item	Vegetation			36.995399 °	36.995471 °
				-120.408809 °	-120.383551 °
DWR ID	DWR_NA0010_16_f_2018_7				
Comment Code					
V9 : Keep the crown roadway free of vegetation.					
Inspector Comment

View of short vegetation on crown between wheel tracks. (Fall 2018)

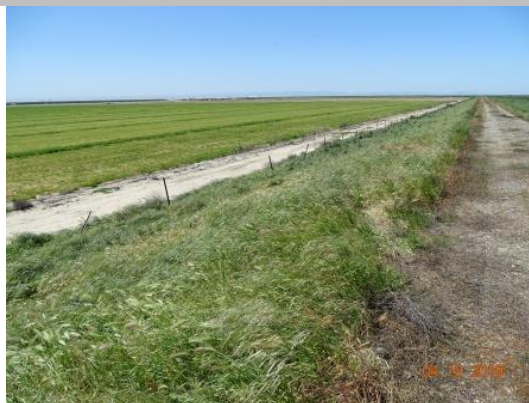
Photo 1 of 2 : SP_2019_NA0010_134_5_20190426_00012.jpg

LM Start	0.01	Rating **	U	Issue No.	5
LM End	1.96	Issue Type +	Ma	Location *	LS
Category	Earthen Levee			GPS Latitude/Longitude	
				Start	End
Item	Vegetation			36.995399 °	°
				-120.408807 °	°
DWR ID	DWR_NA0010_16_f_2018_5				
Comment Code					
V1 : Control annual grass and weeds on the levee slopes and easements.					
Inspector Comment

View of landside slope looking downstream. (Spring 2019)

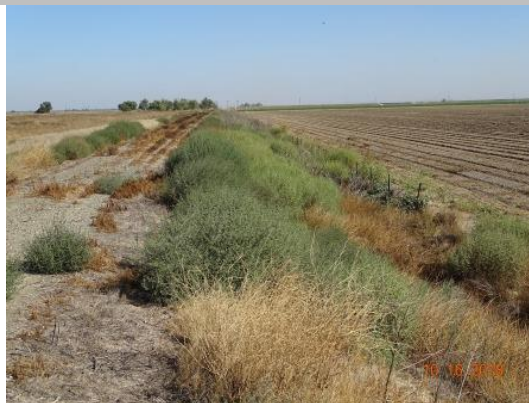
Photo 2 of 2 : SP_2019_NA0010_134_5_20190307_00004.jpg

View of dense vegetation on levee slope and toe. (Fall 2018)

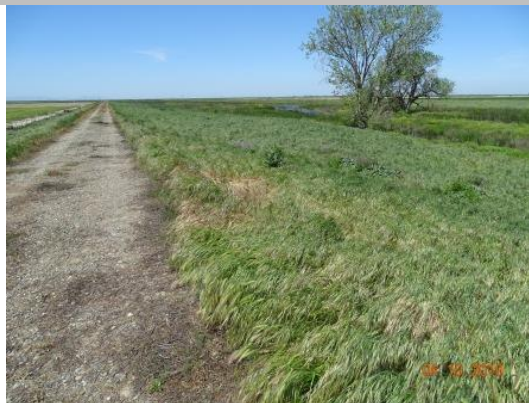
Photo 1 of 2 : SP_2019_NA0010_134_6_20190426_00013.jpg

LM Start	0.01	Rating **	U	Issue No.	6	
LM End	1.96	Issue Type +	Ma	Location *	WS	
Category	Earthen Levee			GPS Latitude/Longitude		
				Start		End
Item	Vegetation			36.995399 °		°
				-120.408805 °		°
DWR ID	DWR_NA0010_16_f_2018_6					
Comment Code						
V1 : Control annual grass and weeds on the levee slopes and easements.						
Inspector Comment

View of waterside slope looking downstream. (Spring 2019)

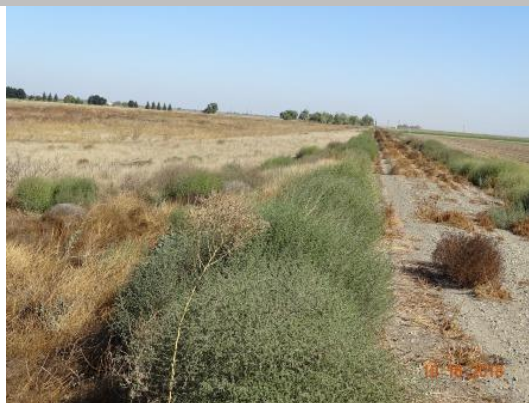
Photo 2 of 2 : SP_2019_NA0010_134_6_20190307_00005.jpg

View of dense vegetation on levee shoulder and slope. (Fall 2018)

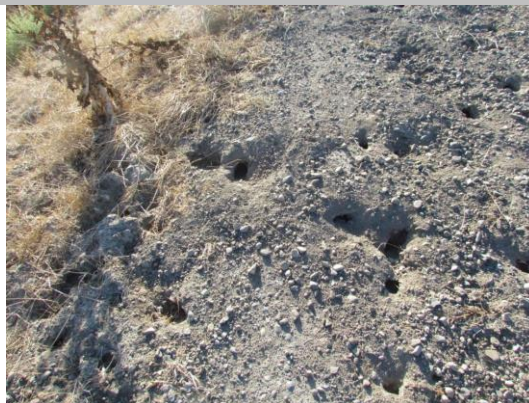
Photo 1 of 1 : SP_2019_NA0010_134_3_20190307_00003.jpg

LM Start	1.09	Rating **	M	Issue No.	3
LM End	1.09	Issue Type +	Ma	Location *	CR
Category	Earthen Levee			GPS Latitude/Longitude	
				Start	End
Item	Animal Control			36.995433 °	36.995433 °
				-120.389190 °	-120.389190 °
DWR ID	DWR_NA0010_16_f_2016_3				
Comment Code					
A3 : No rodents visible, but rodent burrows visible; need to backfill and compact or grout burrows.					
Inspector Comment					
Several rodent holes are identified on the levee crown.

Looking at several rodent holes and mole holes on levee crown.

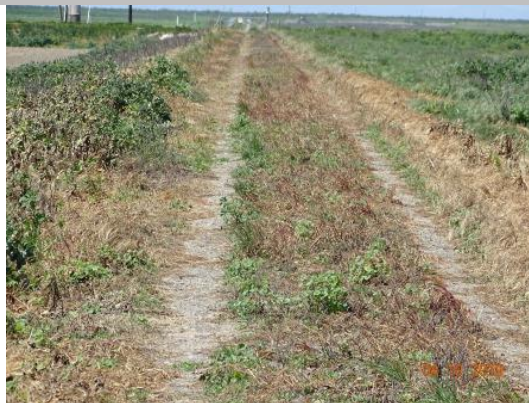
Photo 1 of 2 : SP_2019_NA0010_134_8_20190426_00015.jpg

LM Start	1.43	Rating **	M	Issue No.	8
LM End	1.96	Issue Type +	Ma	Location *	CR
Category	Earthen Levee			GPS Latitude/Longitude	
				Start	End
Item	Vegetation			36.995467 °	36.995467 °
				-120.383087 °	-120.383087 °
DWR ID	DWR_NA0010_16_f_2018_8				
Comment Code					
V9 : Keep the crown roadway free of vegetation.					
Inspector Comment

View of vegetation along levee crown. (Spring 2019)

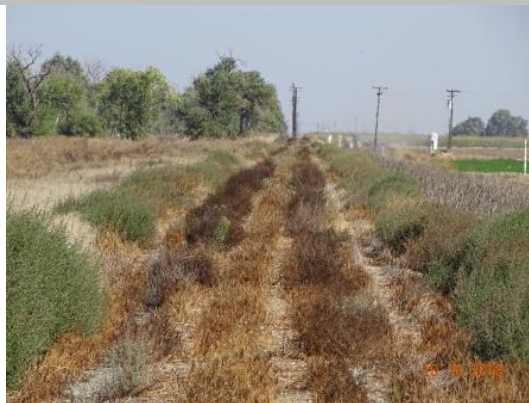
Photo 2 of 2 : SP_2019_NA0010_134_8_20190307_00007.jpg

View of levee crown completely covered in vegetation. (Fall 2018)

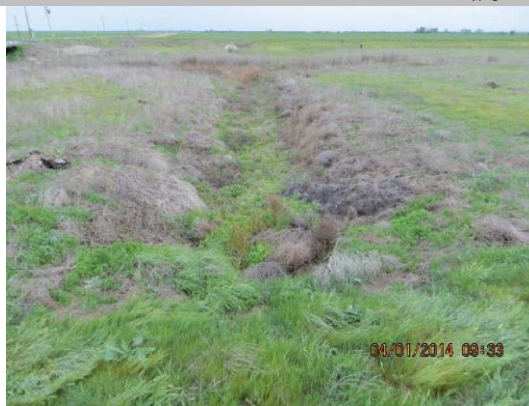
Photo 1 of 3 : UCIP_SP_2019_39529_59681.jpg

Comment Code					
Inspector Comment					
FS_ID:39529 DS_ID:19915 EP_NO: N/A Repair Type: Non-Urgent Crossing Status: Found UCIP Comments: 04/01/2014 Dense vegetation buildup at landside toe--recommend clearing. (DWR UCIP - W. Wylie) FIELD_STRUCT_DESC: 30-inch by 30-inch square reinforced concrete box gravity drainage culvert through the levee, 8.5 feet below the crown. Two concrete cutoff walls. Flap gate on the waterside (WS) end. Concrete headwall on the landside (LS) end. Concrete U-shaped headwall on the WS end. [Additional Reference(s): DWR Levee Log, 2002. USACE San Joaquin O&M Manual 601.1, 1967, (HLM 1.46)]. FS Date: 4/1/2014 8:12:00 AM

Concrete headwall on WS toe with channel.

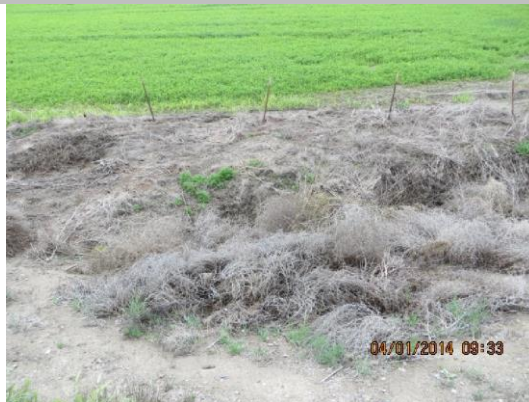
Photo 3 of 3 : UCIP_SP_2019_39529_59682.jpg

Concrete headwall on LS toe covered in vegetation/tumble weeds.

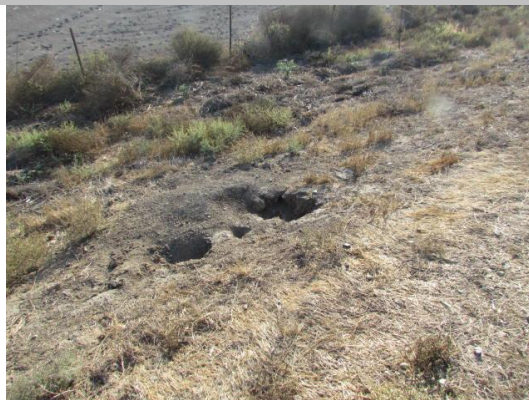
Photo 2 of 2 : SP_2019_NA0010_134_2_20190307_00002.jpg

Looking southwest at several rodent holes on landward slope.

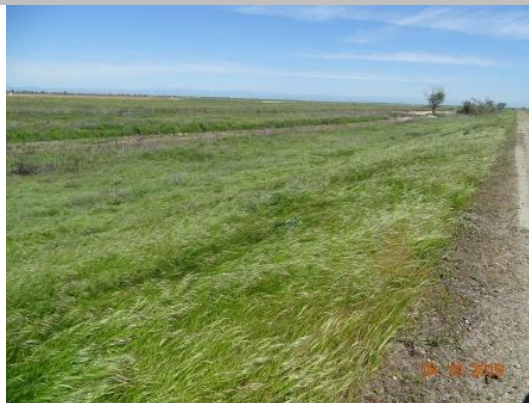
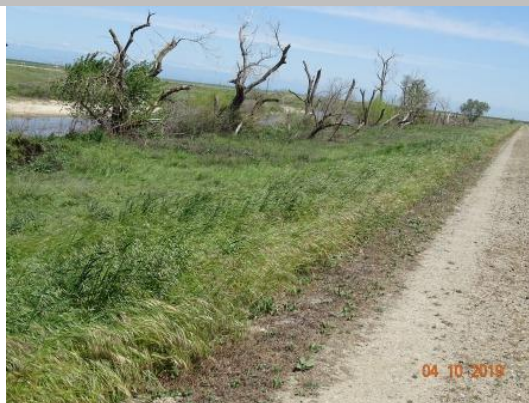
LM Start	0.00	Rating **	U	Issue No.	13
LM End	11.16	Issue Type +	Ma	Location *	LS
Category	Earthen Levee			GPS Latitude/Longitude	
				Start	End
Item	Vegetation			36.976435 °	36.835430 °
				-120.374716 °	-120.303711 °
DWR ID	DWR_NA0010_17_f_2018_13				
Comment Code					
V1 : Control annual grass and weeds on the levee slopes and easements.					
Inspector Comment

View of landside slope looking upstream. (Spring 2019)

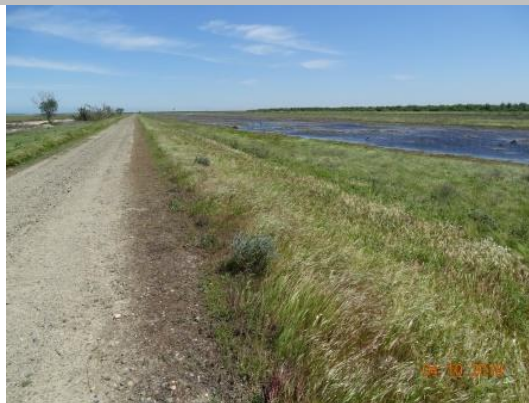
Photo 1 of 1 : SP_2019_NA0010_135_14_20190426_00055.jpg

LM Start	0.00	Rating **	U	Issue No.	14
LM End	11.09	Issue Type +	Ma	Location *	WS
Category	Earthen Levee			GPS Latitude/Longitude	
				Start	End
Item	Vegetation			36.976459 °	36.836143 °
				-120.374671 °	-120.304602 °
DWR ID	DWR_NA0010_17_f_2018_14				
Comment Code					
V1 : Control annual grass and weeds on the levee slopes and easements.					
Inspector Comment

View of waterside slope looking upstream. (Spring 2019)

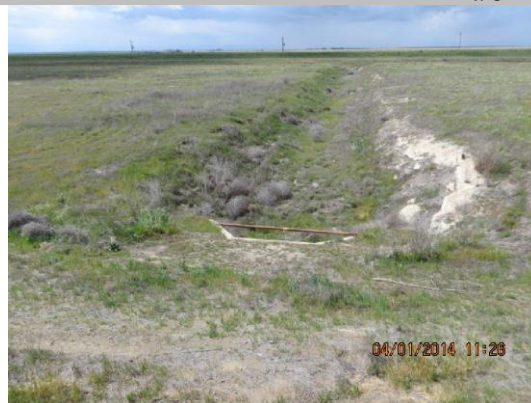
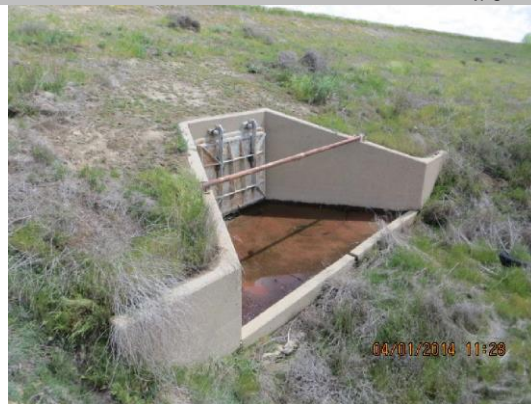
Comment Code					
Inspector Comment					
FS_ID:39531 DS_ID:19916 EP_NO: N/A Repair Type: Non-Urgent Crossing Status: Found UCIP Comments: 04/01/2014 Dense vegetation limits the inspector's visibility to identify signs of pipe failure (leaks) along the landward slope. Recommend removing vegetation along pipe alignment to conduct proper inspection of structure. (DWR UCIP - W. Wylie) FIELD_STRUCT_DESC: 48-inch by 60-inch reinforced concrete box gravity drainage culvert through the levee, 14.6 feet below the crown. Flap gate on the waterside (WS) end. Concrete headwall on the landside (LS) end. Concrete U-shaped headwall on the WS end. [Additional Reference(s): DWR Levee Log, 2002. USACE San Joaquin O&M Manual 601.1, 1967, (HLM 2.58)]. FS Date: 4/1/2014

Concrete headwall at channel on WS toe.

Flapgate on Concrete headwall at WS toe.

Concrete headwall at LS toe.

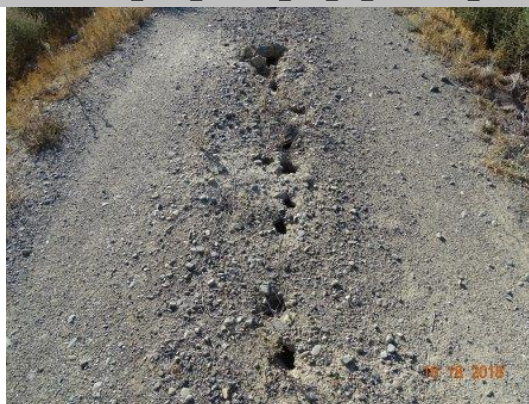
Photo 1 of 1 : SP_2019_NA0010_135_26_20190307_00017.jpg

LM Start	3.79	Rating **	M	Issue No.	26
LM End	3.79	Issue Type +	Ma	Location *	CR
Category	Earthen Levee			GPS Latitude/Longitude	
				Start	End
Item	Animal Control			36.935744 °	36.935744 °
				-120.341077 °	-120.341077 °
DWR ID	DWR_NA0010_17_f_2018_26				
Comment Code					
A3 : No rodents visible, but rodent burrows visible; need to backfill and compact or grout burrows.					
Inspector Comment

View of rodent holes along the center of the crown. (Fall 2018)

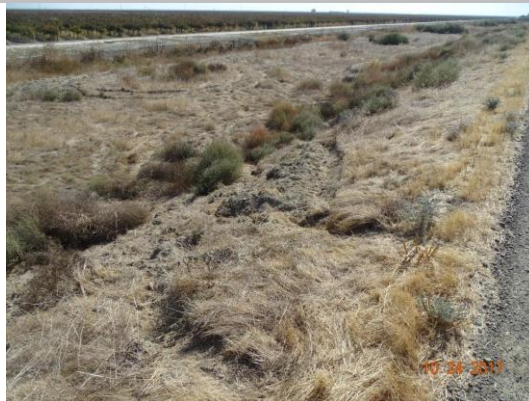
Photo 1 of 1 : SP_2019_NA0010_135_22_20190307_00012.jpg

LM Start	4.74	Rating **	M	Issue No.	22
LM End	4.74	Issue Type +	Ma	Location *	LS
Category	Earthen Levee			GPS Latitude/Longitude	
				Start	End
Item	Slope Stability			36.922526 °	36.922526 °
				-120.336227 °	-120.336227 °
DWR ID	DWR_NA0010_17_f_2017_22				
Comment Code					
S3 : Repair the levee slope damaged by vehicle traffic and prevent access where possible.					
Inspector Comment

Looking southeast at the landside slope.
