**Flood Control Project Maintenance
Levee Inspections**
LMA District Cover Sheet
Spring 2019 Levee Inspection Results

Lower San Joaquin Levee District

Spring 2019 Levee Inspection Results

Waterway			Bank	Unit Miles
Unit No. 01 San Joaquin River			Right	22.52
	Spring (March - May)	Summer (June - August)	(September - November) Fall	Winter (December - February)
Unit Maintenance Rating (Fall Only)				
Date of Inspection	3/26/2019 - 3/26/2019			
DWR Inspector	Corey Fujitani			
Accompanied By

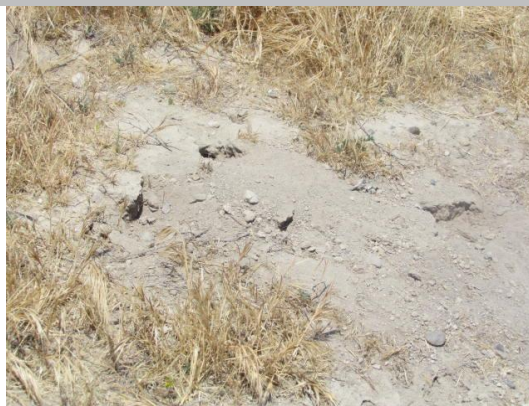
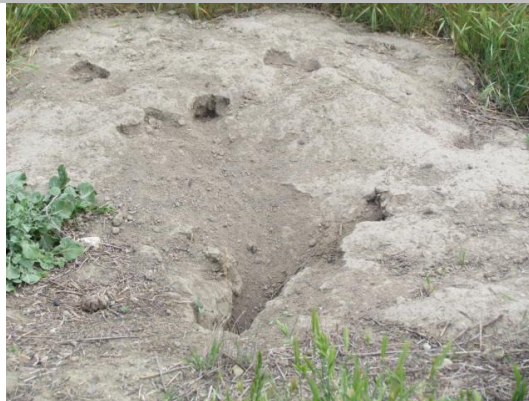
LM Start	5.75	Rating **	M	Issue No.	8
LM End	5.90	Issue Type +	Ma	Location *	LS
Category	Earthen Levee			GPS Latitude/Longitude	
				Start	End
Item	Animal Control			36.908605 °	36.906507 °
				-120.331112 °	-120.330353 °
DWR ID	DWR_NA0010_17_s_2012_8				
Comment Code					
A1 : Exterminate rodents and backfill and compact or grout burrows.					
Inspector Comment					
Multiple rodent holes are noted on the landside slope.

Looking at several rodent holes on landward slope. (Spring 2015)

Looking at several rodent holes on landside slope. (Fall 2014)

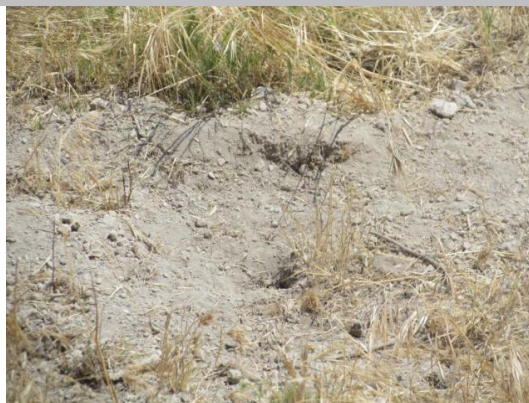
Photo 1 of 1 : SP_2019_NA0010_135_5_20190307_00004.jpg

LM Start	7.27	Rating **	M	Issue No.	5
LM End	7.38	Issue Type +	Ma	Location *	LS
Category	Earthen Levee			GPS Latitude/Longitude	
				Start	End
Item	Animal Control			36.887852 °	36.886388 °
				-120.321668 °	-120.320950 °
DWR ID	DWR_NA0010_17_s_2012_5				
Comment Code					
A3 : No rodents visible, but rodent burrows visible; need to backfill and compact or grout burrows.					
Inspector Comment					
Several rodent holes are identified within this reach.

Looking at typical view of rodent holes on landward slope.

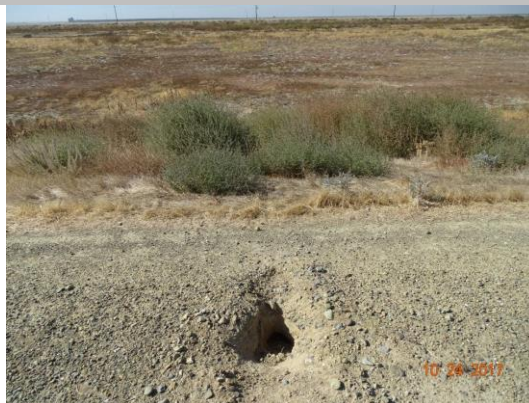
Photo 1 of 1 : SP_2019_NA0010_135_23_20190307_00013.jpg

LM Start	7.41	Rating **	M	Issue No.	23
LM End	7.41	Issue Type +	Ma	Location *	CR
Category	Earthen Levee			GPS Latitude/Longitude	
				Start	End
Item	Animal Control			36.885998 °	36.885998 °
				-120.320759 °	-120.320759 °
DWR ID	DWR_NA0010_17_f_2017_23				
Comment Code					
A3 : No rodents visible, but rodent burrows visible; need to backfill and compact or grout burrows.					
Inspector Comment

Looking southwest at the crown.

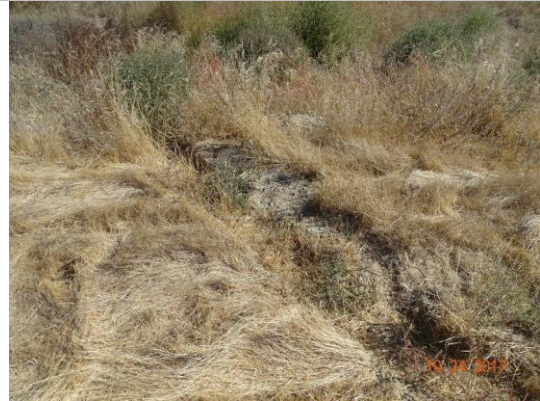
Photo 1 of 1 : SP_2019_NA0010_135_24_20190307_00014.jpg

LM Start	8.15	Rating **	M	Issue No.	24
LM End	8.15	Issue Type +	Ma	Location *	LS
Category	Earthen Levee			GPS Latitude/Longitude	
				Start	End
Item	Animal Control			36.875525 °	36.875525 °
				-120.317788 °	-120.317788 °
DWR ID	DWR_NA0010_17_f_2017_24				
Comment Code					
A3 : No rodents visible, but rodent burrows visible; need to backfill and compact or grout burrows.					
Inspector Comment					
Rodent holes are on the landside and crown of levee. Rodent holes have caused some erosion on the landside slope.

Looking east at the landside slope.

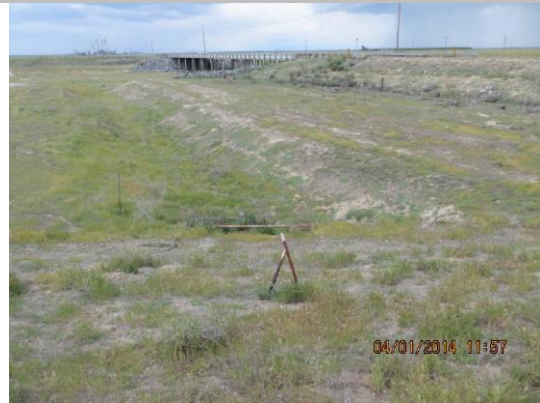
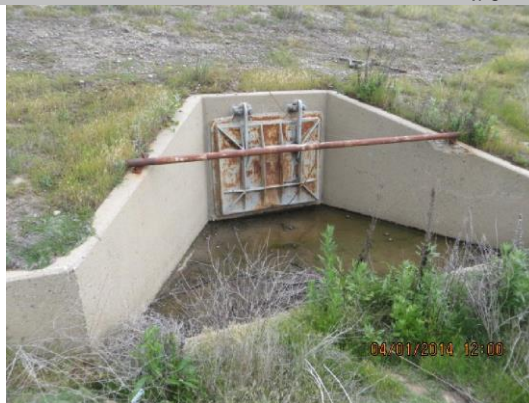
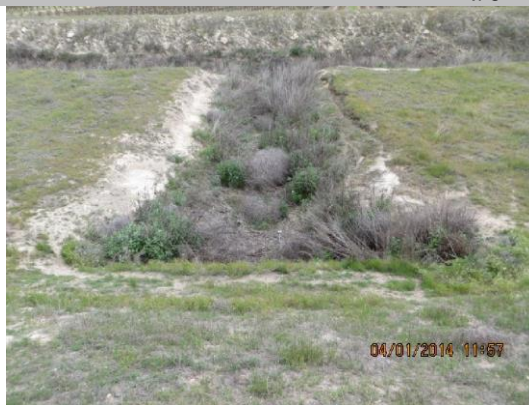
LM Start	8.37	Rating **	A/W	Issue No.	41
LM End	8.37	Issue Type +	Ma	Location *	
Category	Supplemental			GPS Latitude/Longitude	
				Start	End
Item	DWR UCIP LMA Responsibility			36.872358 °	36.872358 °
				-120.317170 °	-120.317170 °
DWR ID	19922				
Comment Code					
Inspector Comment					
FS_ID:32999 DS_ID:19922 EP_NO: N/A Repair Type: No Action Needed Crossing Status: Found UCIP Comments: FIELD_STRUCT_DESC: 48-inch by 60-inch reinforced concrete box gravity drainage culvert through the levee, 16.5 feet below the crown. Flap gate on the waterside (WS) end. Concrete headwall on the landside (LS) end. Concrete U-shaped headwall on the WS end. [Additional Reference(s): DWR Levee Log, 2002. USACE San Joaquin O&M Manual 601.1, 1967, (HLM 8.38)]. FS Date: 4/1/2014

Concrete headwall and channel on WS toe.

Flapgate on concrete headwall at WS toe.

Concrete headwall and channel on LS toe.

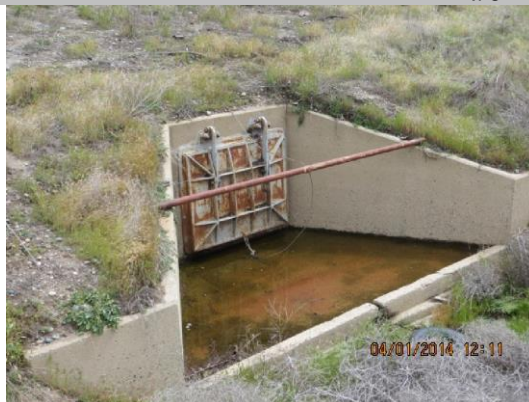
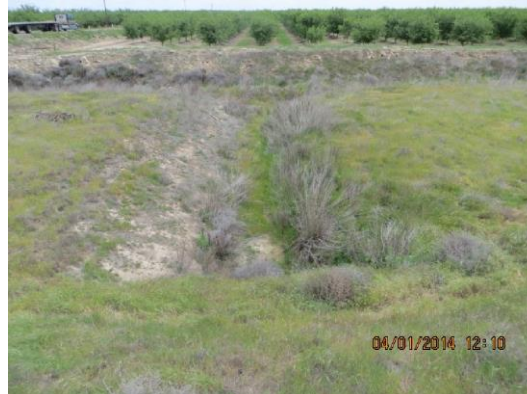
Comment Code					
Inspector Comment					
FS_ID:39532					
DS_ID:19917					
EP_NO: N/A					
Repair Type: Non-Urgent					
Crossing Status: Found					
UCIP Comments: 04/01/2014 Dense vegetation limits the inspector's visibility to identify signs of pipe failure (leaks) along the landward slope. Recommend removing vegetation along pipe alignment to conduct proper inspection of structure. (DWR UCIP - W. Wylie)					
FIELD_STRUCT_DESC: 48-inch by 60-inch reinforced concrete box gravity drainage culvert through the levee, 15 feet below the crown. Concrete headwall on the landside (LS) end. Concrete U-shaped headwall on the waterside (WS) end. [Additional Reference(s): DWR Levee Log, 2002. USACE San Joaquin O&M Manual 601.1, 1967, (HLM 9.89)].					
FS Date: 4/1/2014

Concrete headwall and channel on WS toe.

Flapgate on Concrete headwall at WS toe.

Concrete headwall and channel on LS toe.

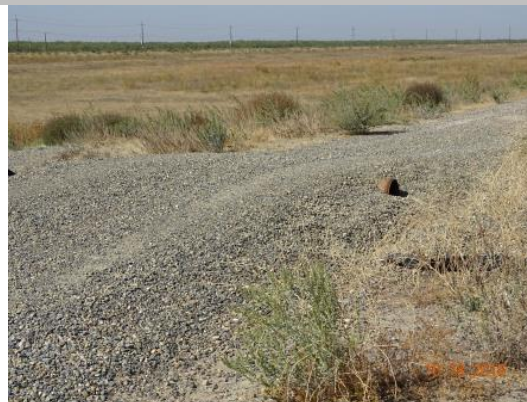
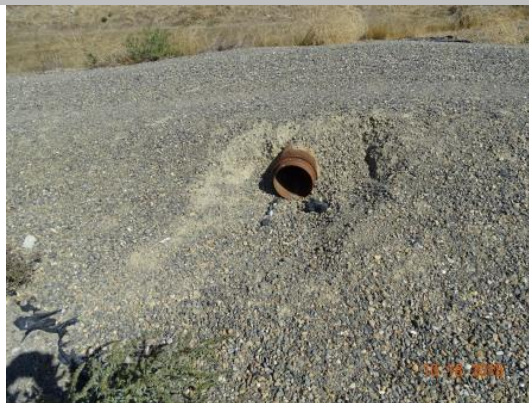
LM Start	11.03	Rating **	M	Issue No.	35
LM End	11.03	Issue Type +	En	Location *	CR
Category	Earthen Levee			GPS Latitude/Longitude	
				Start	End
Item	Encroachments			36.836724 °	36.836724 °
				-120.305328 °	-120.305328 °
DWR ID	DWR_NA0010_17_f_2018_35				
Comment Code					
PI : Pipe					
Inspector Comment					
Landowner installed a pipe across the levee crown.

View of pipe encroachment looking downstream. (Fall 2018)

View of pipe encroachment looking across crown. (Fall 2018)

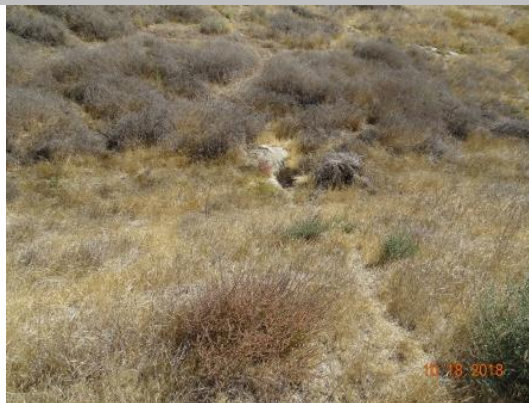
Photo 1 of 2 : SP_2019_NA0010_135_39_20190307_00027.jpg

LM Start	12.17	Rating **	U	Issue No.	39
LM End	12.17	Issue Type +	Ma	Location *	LS
Category	Earthen Levee			GPS Latitude/Longitude	
				Start	End
Item	Animal Control			36.822818 °	36.822818 °
				-120.299680 °	-120.299680 °
DWR ID	DWR_NA0010_17_f_2018_39				
Comment Code					
A3 : No rodents visible, but rodent burrows visible; need to backfill and compact or grout burrows.					
Inspector Comment					
A large hole is on the landside toe.

Large rodent hole at toe of levee. (Fall 2018)

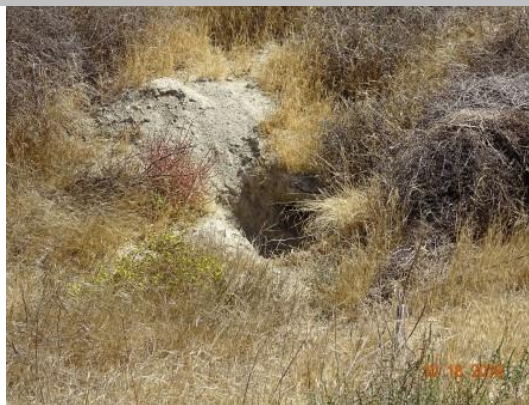
Photo 2 of 2 : SP_2019_NA0010_135_39_20190307_00028.jpg

LM Start	12.17	Rating **	U	Issue No.	39 (cont)
LM End	12.17	Issue Type +	Ma	Location *	LS

Upclose view of rodent hole. (Fall 2018)

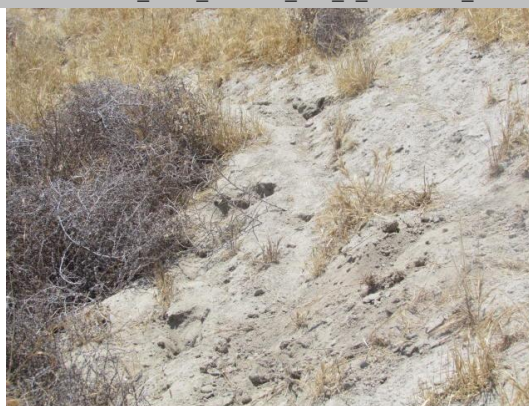
Photo 2 of 2 : SP_2019_NA0010_135_3_20190307_00002.jpg

LM Start	12.28	Rating **	M	Issue No.	3 (cont)	
LM End	12.38	Issue Type +	Ma	Location *	LS	
Category	Earthen Levee			GPS Latitude/Longitude		
				Start		End
Item	Animal Control			36.821368 °		36.820000 °
				-120.300283 °		-120.300831 °
DWR ID	DWR_NA0010_17_s_2014_3					
Comment Code						
A3 : No rodents visible, but rodent burrows visible; need to backfill and compact or grout burrows.						
Inspector Comment						
Several rodent holes are identified within this reach.

Looking at several rodent holes on landward slope. Spring 2015

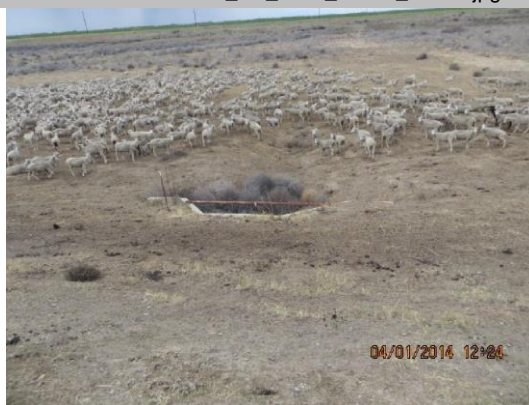
Photo 1 of 3 : UCIP_SP_2019_39533_59727.jpg

LM Start	13.29	Rating **	M	Issue No.	43
LM End	13.29	Issue Type +	Ma	Location *	
Category	Supplemental			GPS Latitude/Longitude	
				Start	End
Item	DWR UCIP LMA Responsibility			36.807509 °	36.807509 °
				-120.306231 °	-120.306231 °
DWR ID	19918				
Comment Code					
Inspector Comment					
FS_ID:39533 DS_ID:19918 EP_NO: N/A Repair Type: Non-Urgent Crossing Status: Found UCIP Comments: 04/01/2014 Some vegetation buildup at inlet-- recommend clearing. (DWR UCIP - W. Wylie) FIELD_STRUCT_DESC: 48-inch by 60-inch reinforced concrete box gravity drainage culvert through the levee, 15.3 feet below the crown. Flap gate on the waterside (WS) end. Concrete headwall on the landside (LS) end. Concrete U-shaped headwall on the WS end. [Additional Reference(s): DWR Levee Log, 2002. USACE San Joaquin O&M Manual 601.1, 1967, (HLM 13.30)]. FS Date: 4/1/2014

Concrete headwall on WS toe.

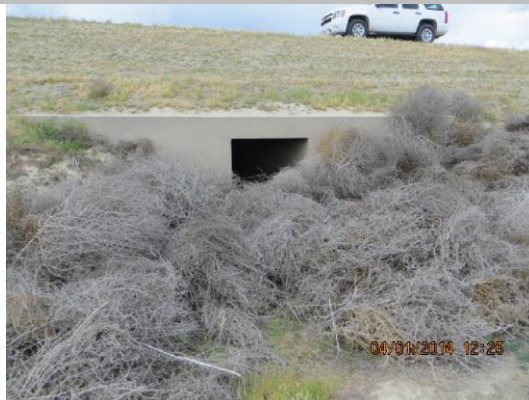
Photo 3 of 3 : UCIP_SP_2019_39533_59725.jpg

LM Start	13.29	Rating **	M	Issue No.	43 (cont)
LM End	13.29	Issue Type +	Ma	Location *

Concrete headwall on LS toe. Some vegetation buildup.

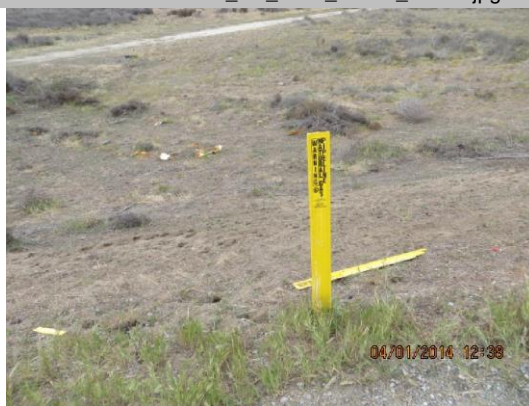
Photo 1 of 3 : UCIP_SP_2019_41406_71490.jpg

LM Start	14.38	Rating **	M	Issue No.	44
LM End	14.38	Issue Type +	En	Location *	
Category	Supplemental			GPS Latitude/Longitude	
				Start	End
Item	DWR UCIP Field Study			36.793318 °	36.793318 °
				-120.302138 °	-120.302138 °
DWR ID	24850				
Comment Code					
Inspector Comment					
FS_ID:41406					
DS_ID:24850					
EP_NO: N/A					
Repair Type: Non-Urgent					
Crossing Status: Indicator Found					
UCIP Comments: 04/01/2014 No permit identified for this crossing.					
(DWR UCIP - W. Wylie)					
FIELD_STRUCT_DESC: Natural gas pipeline of an unknown size or material through the levee, at an unknown depth. Gas line markers on both shoulders.					
FS Date: 4/1/2014

Gasline marker on WS slope..

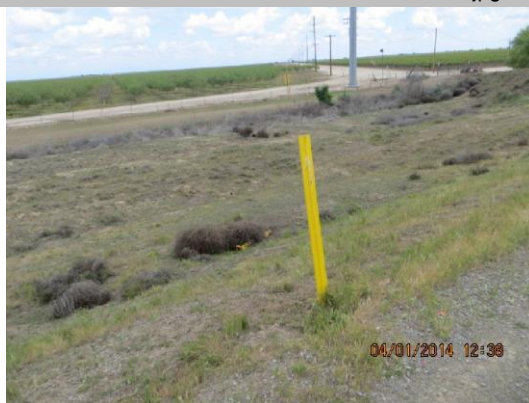
Photo 2 of 3 : UCIP_SP_2019_41406_71489.jpg

LM Start	14.38	Rating **	M	Issue No.	44 (cont)
LM End	14.38	Issue Type +	En	Location *

Gasline marker on LS shoulder.

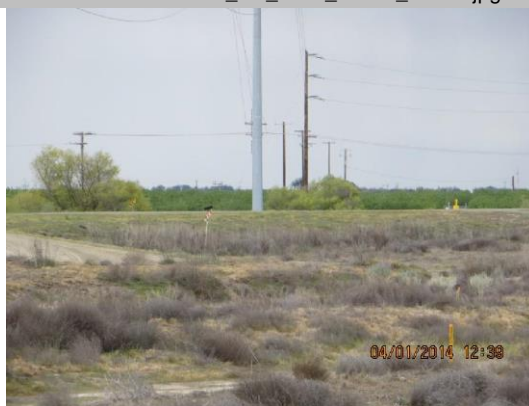
Photo 3 of 3 : UCIP_SP_2019_41406_71488.jpg

LM Start	14.38	Rating **	M	Issue No.	44 (cont)	
LM End	14.38	Issue Type +	En	Location *		
Category	Supplemental			GPS Latitude/Longitude		
				Start	End	
Item	DWR UCIP Field Study			36.793318 °	36.793318 °	
				-120.302138 °	-120.302138 °	
DWR ID	24850					
Comment Code						
Inspector Comment						
FS_ID:41406						
DS_ID:24850						
EP_NO: N/A						
Repair Type: Non-Urgent						
Crossing Status: Indicator Found						
UCIP Comments: 04/01/2014 No permit identified for this crossing.						
(DWR UCIP - W. Wylie)						
FIELD_STRUCT_DESC: Natural gas pipeline of an unknown size or material through the levee, at an unknown depth. Gas line markers on both shoulders.						
FS Date: 4/1/2014

Gasline markers visible along right side of photo.

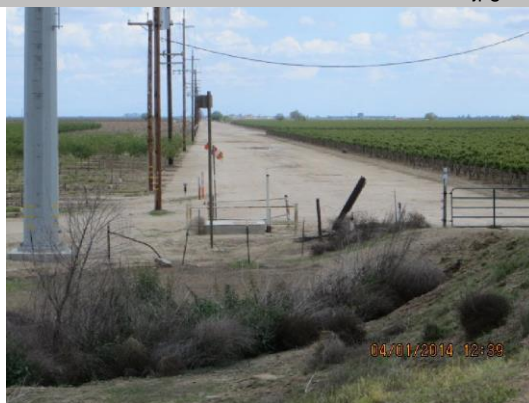
Photo 1 of 3 : UCIP_SP_2019_50067_59742.jpg

LM Start	14.39	Rating **	M	Issue No.	45
LM End	14.39	Issue Type +	En	Location *	
Category	Supplemental			GPS Latitude/Longitude	
				Start	End
Item	DWR UCIP Field Study			36.793195 °	36.793195 °
				-120.302028 °	-120.302028 °
DWR ID	19562

Comment Code					
Inspector Comment					
FS_ID:50067 DS_ID:19562 EP_NO: 18568 Repair Type: Non-Urgent Crossing Status: Indicator Found UCIP Comments: 7/20/2016 Marker visible on LS. WS marker missing. (DWR UCIP - omagana)4/01/2014 Need to contact owner to confirm and obtain status of crossing. Markers misleading--unable to confirm if markers correspond to this crossing. Need markers at levee. (DWR UCIP - wwylie) FIELD_STRUCT_DESC: 30-inch coated steel natural gas pipeline through the levee, approximately 60 feet below the crown. Gas line markers are visible on the waterside (WS) and the landside (LS). (30-inch horizontal directional bore (HDD) authorized under Permit No. 18568, 2010 - Gill Ranch Storage, LLC). FS Date: 7/20/2016

Gasline marker and concrete sump off LS toe.

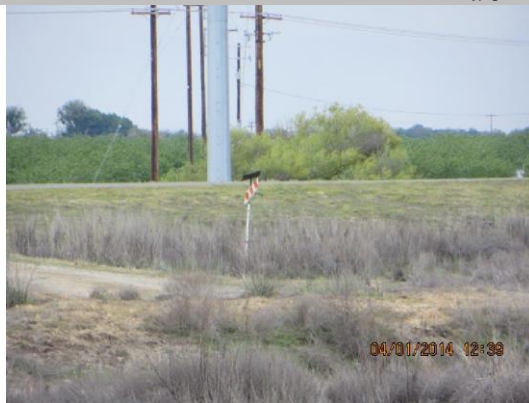
Photo 2 of 3 : UCIP_SP_2019_50067_59741.jpg

Comment Code						
Inspector Comment						
FS_ID:50067 DS_ID:19562 EP_NO: 18568 Repair Type: Non-Urgent Crossing Status: Indicator Found UCIP Comments: 7/20/2016 Marker visible on LS. WS marker missing. (DWR UCIP - omagana)4/01/2014 Need to contact owner to confirm and obtain status of crossing. Markers misleading--unable to confirm if markers correspond to this crossing. Need markers at levee. (DWR UCIP - wwylie) FIELD_STRUCT_DESC: 30-inch coated steel natural gas pipeline through the levee, approximately 60 feet below the crown. Gas line markers are visible on the waterside (WS) and the landside (LS). (30-inch horizontal directional bore (HDD) authorized under Permit No. 18568, 2010 - Gill Ranch Storage, LLC). FS Date: 7/20/2016

Gasline marker visible in channell off WS toe.

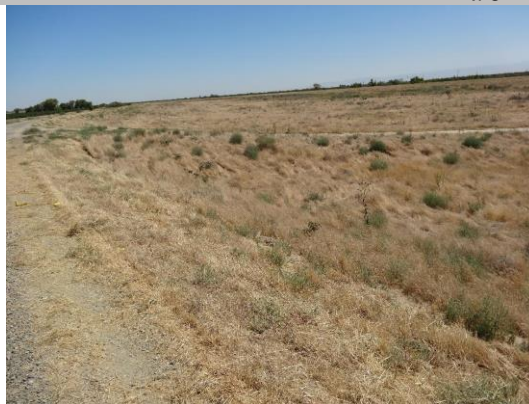
Photo 3 of 3 : UCIP_SP_2019_50067_75506.jpg

LM Start	14.39	Rating **	M	Issue No.	45 (cont)
LM End	14.39	Issue Type +	En	Location *

View of WS.

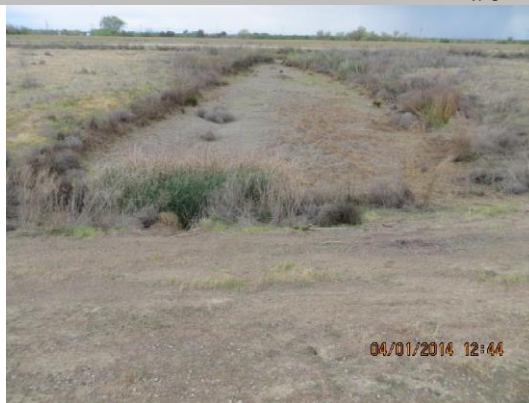
Photo 1 of 3 : UCIP_SP_2019_39535_59745.jpg

LM Start	14.69	Rating **	M	Issue No.	46
LM End	14.69	Issue Type +	Ma	Location *	
Category	Supplemental			GPS Latitude/Longitude	
				Start	End
Item	DWR UCIP LMA Responsibility			36.789066 °	36.789066 °
				-120.300644 °	-120.300644 °
DWR ID	19920				
Comment Code					
Inspector Comment					
FS_ID:39535 DS_ID:19920 EP_NO: N/A Repair Type: Non-Urgent Crossing Status: Found UCIP Comments: 04/01/2014 Heavy vegetation buildup at LS toe-- recommend clearing. (DWR UCIP - W. Wylie) FIELD_STRUCT_DESC: 30-inch by 30-inch square reinforced concrete box gravity drainage culvert through the levee, 14 feet below the crown. Flap gate on the waterside (WS) end. Concrete headwall on the landside (LS) end. Concrete U-shaped headwall on the WS end. [Additional Reference(s): DWR Levee Log, 2002. USACE San Joaquin O&M Manual 601.1, 1967, (HLM 14.69)]. FS Date: 4/1/2014

Concrete headwall at WS toe.

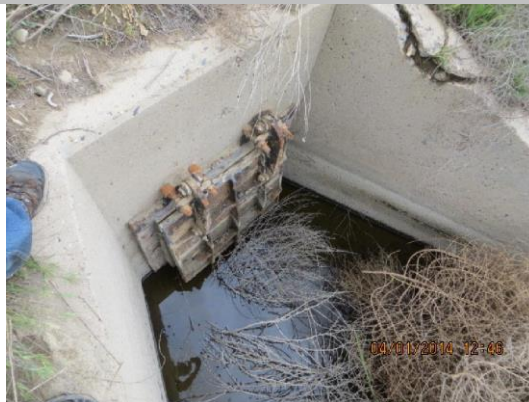
Photo 2 of 3 : UCIP_SP_2019_39535_59747.jpg

LM Start	14.69	Rating **	M	Issue No.	46 (cont)
LM End	14.69	Issue Type +	Ma	Location *

Flapgate on Concrete headwall at WS toe.

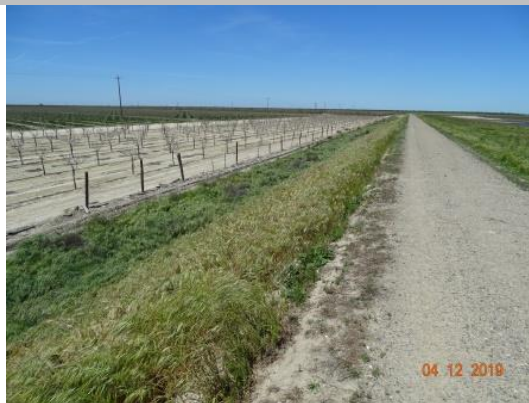
Photo 1 of 1 : SP_2019_NA0010_137_71_20190429_00043.jpg

LM Start	0.02	Rating **	U	Issue No.	71
LM End	1.34	Issue Type +	Ma	Location *	LS
Category	Earthen Levee			GPS Latitude/Longitude	
				Start	End
Item	Vegetation			36.973991 °	36.957440 °
				-120.363070 °	-120.354468 °
DWR ID	DWR_NA0010_18_s_2019_71				
Comment Code					
V1 : Control annual grass and weeds on the levee slopes and easements.					
Inspector Comment

View along landside slope looking downstream. (Spring 2019)

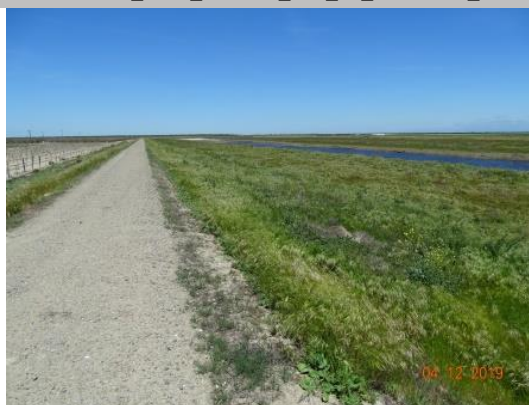
Photo 1 of 1 : SP_2019_NA0010_137_72_20190429_00044.jpg

LM Start	0.02	Rating **	U	Issue No.	72
LM End	1.34	Issue Type +	Ma	Location *	WS
Category	Earthen Levee			GPS Latitude/Longitude	
				Start	End
Item	Vegetation			36.973990 °	36.957439 °
				-120.363068 °	-120.354467 °
DWR ID	DWR_NA0010_18_s_2019_72				
Comment Code					
V1 : Control annual grass and weeds on the levee slopes and easements.					
Inspector Comment

View along waterside slope looking downstream. (Spring 2019)

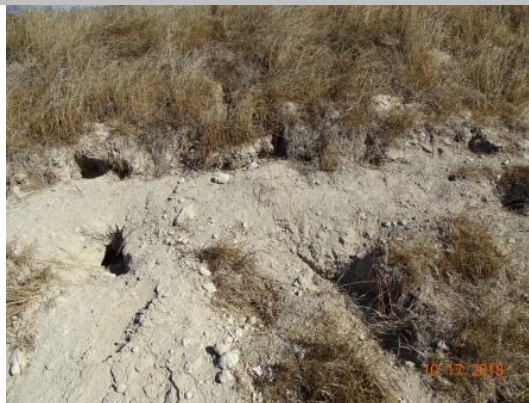
Photo 1 of 1 : SP_2019_NA0010_137_55_20190307_00028.jpg

LM Start	0.78	Rating **	M	Issue No.	55
LM End	0.78	Issue Type +	Ma	Location *	LS
Category	Earthen Levee			GPS Latitude/Longitude	
				Start	End
Item	Animal Control			36.964824 °	36.964824 °
				-120.358065 °	-120.358065 °
DWR ID	DWR_NA0010_18_f_2018_55				
Comment Code					
A3 : No rodents visible, but rodent burrows visible; need to backfill and compact or grout burrows.					
Inspector Comment

View of rodent holes from levee toe looking towards centerline. (Fall 2018)

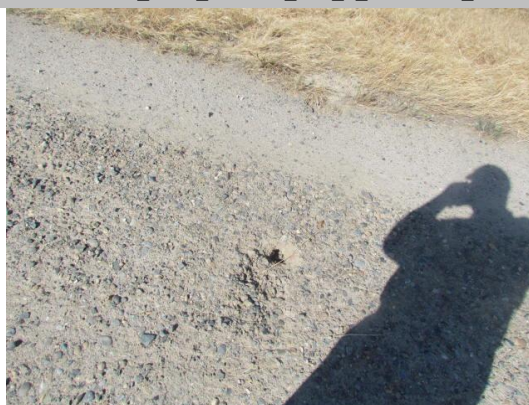
Photo 1 of 1 : SP_2019_NA0010_137_7_20190307_00002.jpg

LM Start	1.44	Rating **	M	Issue No.	7
LM End	1.44	Issue Type +	Ma	Location *	LS
Category	Earthen Levee			GPS Latitude/Longitude	
				Start	End
Item	Animal Control			36.956163 °	36.956163 °
				-120.353672 °	-120.353672 °
DWR ID	DWR_NA0010_18_f_2018_7				
Comment Code					
A3 : No rodents visible, but rodent burrows visible; need to backfill and compact or grout burrows.					
Inspector Comment					
There are several rodent holes identified on landside slope and on the levee crown.

Looking at typical view of rodent holes within this section on landward slope.

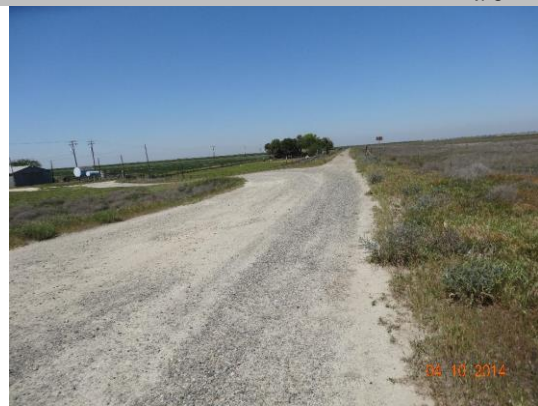
Photo 1 of 3 : UCIP_SP_2019_39503_66660.jpg

Comment Code						
Inspector Comment						
FS_ID:39503 DS_ID:19925 EP_NO: 6603 Repair Type: Non-Urgent Crossing Status: Found UCIP Comments: 04/10/2014 Need to contact owner. Appears abandoned--good candidate for video or pressure inspection. This crossings is the same age as the pipe that has failed immediately upstream. (DWR UCIP - O. Magana) FIELD_STRUCT_DESC: 15-inch steel irrigation discharge pipe through the levee, 4.3 feet below the crown. Electrical conduit of an unknown size or material through the levee, 4.3 feet below the crown. Siphon breaker on the landside (LS) shoulder. 36-inch concrete standpipe on the LS berm. Inlet facility on the waterside (WS) bank consisting of a pump, a 42-inch concrete standpipe, and a 20-inch concrete channel with an intake pipe and a cutoff wall. (Plans to install a pump and outlet pipe at two locations on the left bank levee of the Chowchilla Bypass authorized under Permit No. 6603, 1969 - Raymond N. Costales). [Additional Reference(s): DWR Levee Log, 2002]. FS Date: 4/10/2014

Overview of levee crown at crossing.

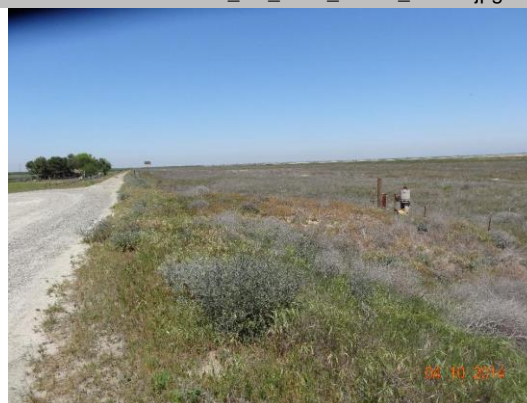
Photo 2 of 3 : UCIP_SP_2019_39503_66657.jpg

Comment Code						
Inspector Comment						
FS_ID:39503 DS_ID:19925 EP_NO: 6603 Repair Type: Non-Urgent Crossing Status: Found UCIP Comments: 04/10/2014 Need to contact owner. Appears abandoned--good candidate for video or pressure inspection. This crossings is the same age as the pipe that has failed immediately upstream. (DWR UCIP - O. Magana) FIELD_STRUCT_DESC: 15-inch steel irrigation discharge pipe through the levee, 4.3 feet below the crown. Electrical conduit of an unknown size or material through the levee, 4.3 feet below the crown. Siphon breaker on the landside (LS) shoulder. 36-inch concrete standpipe on the LS berm. Inlet facility on the waterside (WS) bank consisting of a pump, a 42-inch concrete standpipe, and a 20-inch concrete channel with an intake pipe and a cutoff wall. (Plans to install a pump and outlet pipe at two locations on the left bank levee of the Chowchilla Bypass authorized under Permit No. 6603, 1969 - Raymond N. Costales). [Additional Reference(s): DWR Levee Log, 2002]. FS Date: 4/10/2014

View of waterward side.

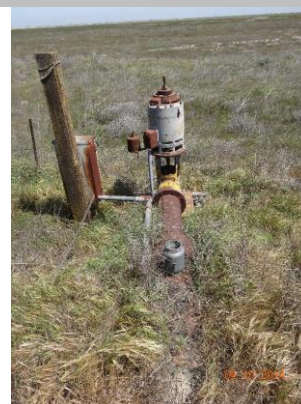
Photo 3 of 3 : UCIP_SP_2019_39503_66658.jpg

Pump system located on waterward slope.

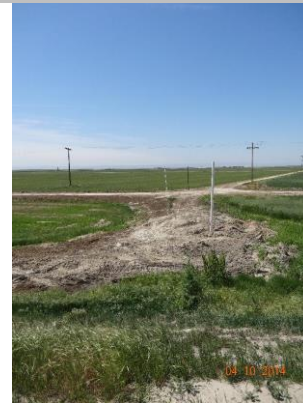
Photo 1 of 3 : UCIP_SP_2019_49968_60558.jpg

Comment Code					
Inspector Comment					
FS_ID:49968 DS_ID:19926 EP_NO: 6603 Repair Type: Non-Urgent Crossing Status: Found UCIP Comments: 7/20/2016 High burrow activity. Dense vegetation limits the inspector's visibility to identify signs of pipe failure (leaks) along the WS and LS slope. Recommend removing vegetation along pipe alignment to conduct proper inspection of structure and appurtenances. (DWR UCIP - omagana)4/10/2014 Subsidence present along pipe alignment on landward side. Modified crossing--worked done on landward side. Need to contact owner to determine permit authorizing work. Dense vegetation on landward side--tall grass. Pipe wall cut and new pipe sleeved on landward side. (DWR UCIP - omagana) FIELD_STRUCT_DESC: 15-inch steel irrigation discharge pipe and electrical conduit through the levee, 3.7 feet below the crown. Siphon breaker on the landside (LS) shoulder. 36-inch concrete standpipe on the LS berm. Inlet facility on the riverbank, consisting of a pump, a 42-inch concrete standpipe, and a 20-inch concrete channel with an intake pipe and a cutoff wall. (Plans to install a pump and outlet pipe at two locations on the left bank levee of the Chowchilla Bypass authorized under Permit No. 6603, 1969 - Raymond N. Costales). [Additional Reference(s): DWR Levee Log, 2002]. FS Date: 7/20/2016

Overview of LS--site modified.

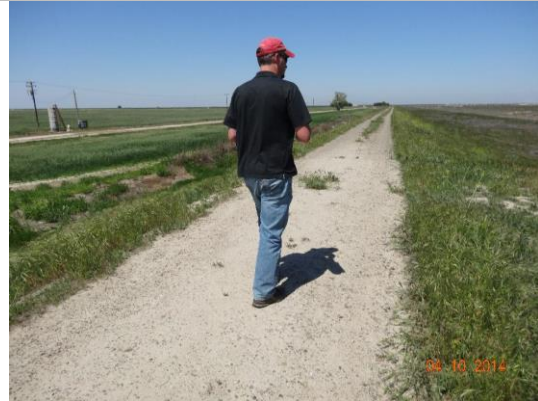
Photo 2 of 3 : UCIP_SP_2019_49968_60559.jpg

Comment Code						
Inspector Comment						
FS_ID:49968 DS_ID:19926 EP_NO: 6603 Repair Type: Non-Urgent Crossing Status: Found UCIP Comments: 7/20/2016 High burrow activity. Dense vegetation limits the inspector's visibility to identify signs of pipe failure (leaks) along the WS and LS slope. Recommend removing vegetation along pipe alignment to conduct proper inspection of structure and appurtenances. (DWR UCIP - omagana)4/10/2014 Subsidence present along pipe alignment on landward side. Modified crossing--worked done on landward side. Need to contact owner to determine permit authorizing work. Dense vegetation on landward side--tall grass. Pipe wall cut and new pipe sleeved on landward side. (DWR UCIP - omagana) FIELD_STRUCT_DESC: 15-inch steel irrigation discharge pipe and electrical conduit through the levee, 3.7 feet below the crown. Siphon breaker on the landside (LS) shoulder. 36-inch concrete standpipe on the LS berm. Inlet facility on the riverbank, consisting of a pump, a 42-inch concrete standpipe, and a 20-inch concrete channel with an intake pipe and a cutoff wall. (Plans to install a pump and outlet pipe at two locations on the left bank levee of the Chowchilla Bypass authorized under Permit No. 6603, 1969 - Raymond N. Costales). [Additional Reference(s): DWR Levee Log, 2002]. FS Date: 7/20/2016

View of levee crown at crossing.

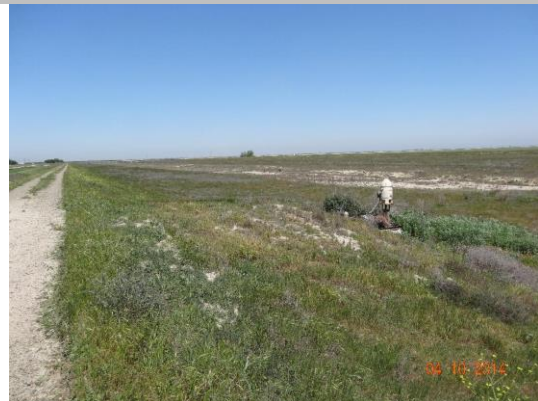
Photo 3 of 3 : UCIP_SP_2019_49968_60560.jpg

View of WS.

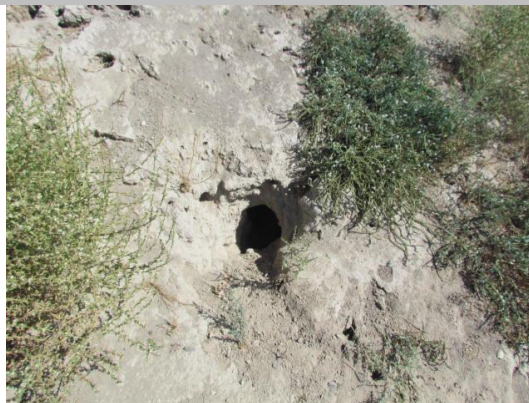
Photo 1 of 2 : SP_2019_NA0010_137_8_20190307_00003.jpg

LM Start	2.25	Rating **	U	Issue No.	8 (cont)
LM End	2.25	Issue Type +	Ma	Location *	LS

Looking at large rodent hole on landward slope.

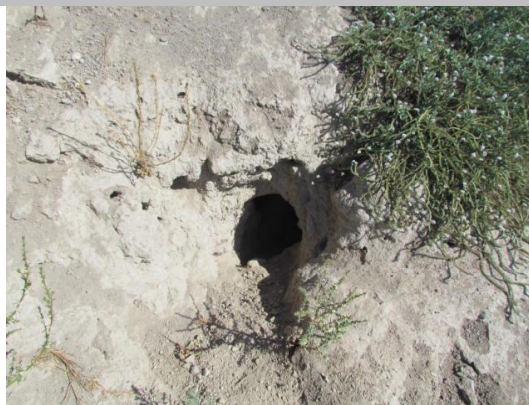
Photo 2 of 2 : SP_2019_NA0010_137_8_20190307_00004.jpg

Looking at close-up view of large rodent hole on landward slope.

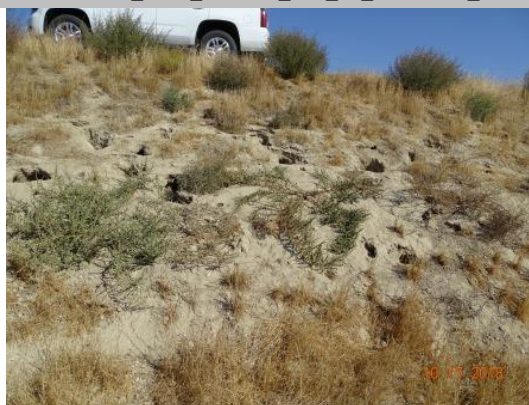
Photo 1 of 1 : SP_2019_NA0010_137_47_20190307_00022.jpg

LM Start	5.77	Rating **	U	Issue No.	47
LM End	5.77	Issue Type +	Ma	Location *	LS
Category	Earthen Levee			GPS Latitude/Longitude	
				Start	End
Item	Animal Control			36.896839 °	36.896839 °
				-120.328434 °	-120.328434 °
DWR ID	DWR_NA0010_18_f_2018_47				
Comment Code					
A3 : No rodents visible, but rodent burrows visible; need to backfill and compact or grout burrows.					
Inspector Comment

Several rodent holes in the landside slope. (Fall 2018)

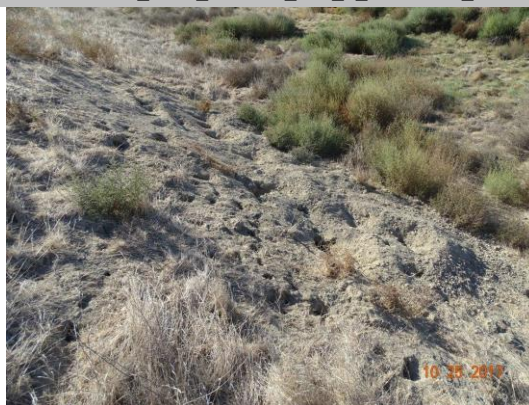
Photo 1 of 1 : SP_2019_NA0010_137_1_20190307_00001.jpg

LM Start	5.89	Rating **	U	Issue No.	1
LM End	5.89	Issue Type +	Ma	Location *	LS
Category	Earthen Levee			GPS Latitude/Longitude	
				Start	End
Item	Animal Control			36.895175 °	36.895175 °
				-120.327632 °	-120.327632 °
DWR ID	DWR_NA0010_18_s_2015_1				
Comment Code					
A3 : No rodents visible, but rodent burrows visible; need to backfill and compact or grout burrows.					
Inspector Comment					
There are several large rodent holes noted on the landside slope and berm within this section.

Looking at the landside slope.

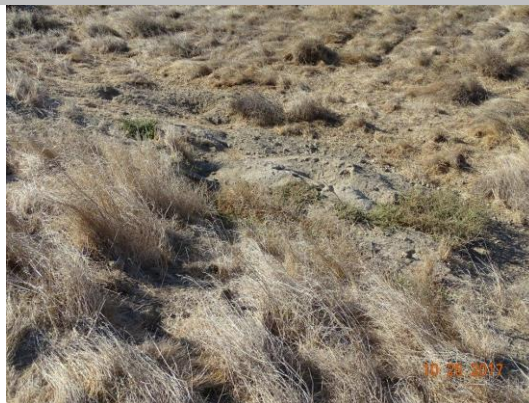
Photo 1 of 1 : SP_2019_NA0010_137_15_20190307_00007.jpg

LM Start	5.99	Rating **	U	Issue No.	15
LM End	5.99	Issue Type +	Ma	Location *	LS
Category	Earthen Levee			GPS Latitude/Longitude	
				Start	End
Item	Animal Control			36.893924 °	36.893924 °
				-120.327020 °	-120.327020 °
DWR ID	DWR_NA0010_18_f_2017_15				
Comment Code					
A3 : No rodents visible, but rodent burrows visible; need to backfill and compact or grout burrows.					
Inspector Comment					
There are multiple large rodent holes at the landside toe.

Looking west at the landside slope. (Fall 2017)

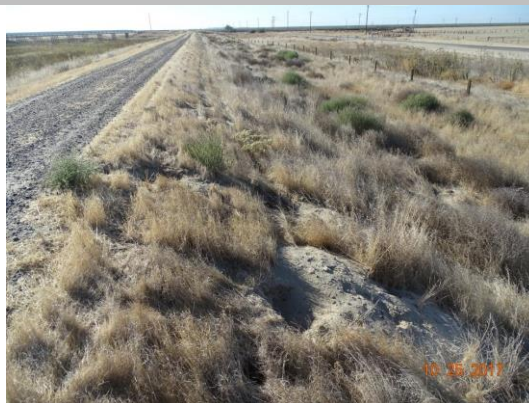
Photo 1 of 1 : SP_2019_NA0010_137_14_20190307_00006.jpg

LM Start	7.39	Rating **	U	Issue No.	14
LM End	7.53	Issue Type +	Ma	Location *	LS
Category	Earthen Levee			GPS Latitude/Longitude	
				Start	End
Item	Animal Control			36.874479 °	36.872503 °
				-120.319831 °	-120.319438 °
DWR ID	DWR_NA0010_18_f_2017_14				
Comment Code					
A3 : No rodents visible, but rodent burrows visible; need to backfill and compact or grout burrows.					
Inspector Comment					
There are several rodent holes noted along the landside slope in this area.

Looking south at the landside slope.

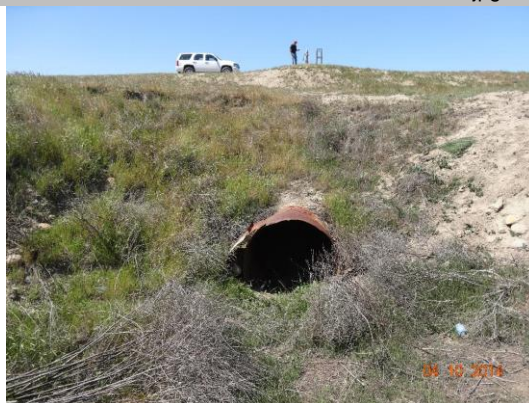
Photo 2 of 3 : UCIP_SP_2019_36843_67205.jpg

Pipe section distorted on waterward side.

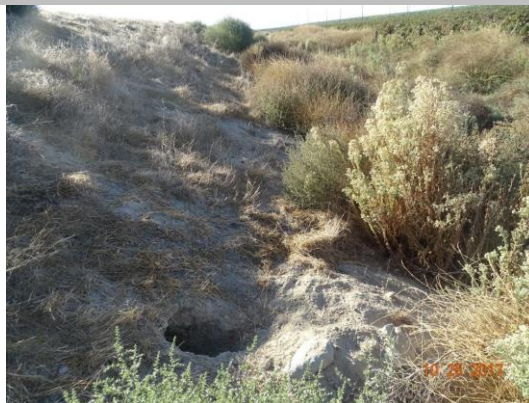
Photo 1 of 1 : SP_2019_NA0010_137_13_20190307_00005.jpg

LM Start	8.67	Rating **	U	Issue No.	13
LM End	8.67	Issue Type +	Ma	Location *	LS
Category	Earthen Levee			GPS Latitude/Longitude	
				Start	End
Item	Animal Control			36.856115 °	36.856115 °
				-120.316595 °	-120.316595 °
DWR ID	DWR_NA0010_18_f_2017_13				
Comment Code					
A3 : No rodents visible, but rodent burrows visible; need to backfill and compact or grout burrows.					
Inspector Comment

Looking south at the landside slope.

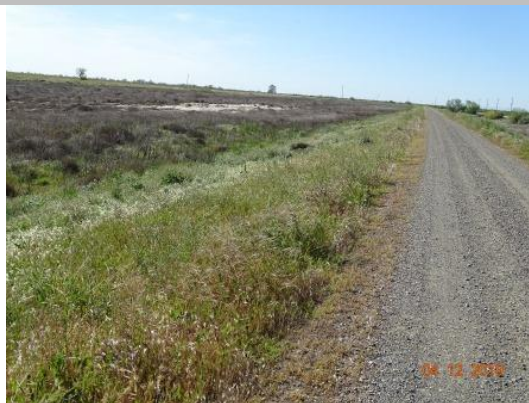
Photo 1 of 1 : SP_2019_NA0010_137_61_20190429_00045.jpg

LM Start	8.93	Rating **	U	Issue No.	61
LM End	15.30	Issue Type +	Ma	Location *	WS
Category	Earthen Levee			GPS Latitude/Longitude	
				Start	End
Item	Vegetation			36.852389 °	36.774046 °
				-120.316424 °	-120.285545 °
DWR ID	DWR_NA0010_18_s_2019_61				
Comment Code					
V1 : Control annual grass and weeds on the levee slopes and easements.					
Inspector Comment

View of waterside slope looking upstream. (Spring 2019)

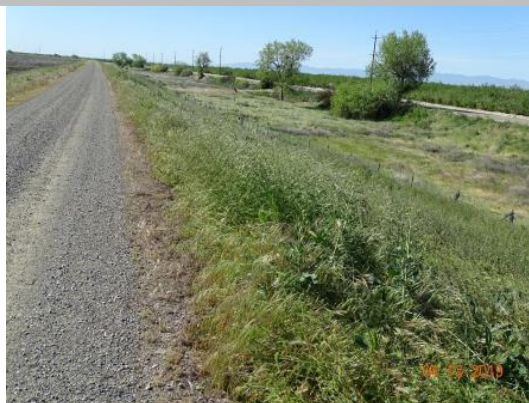
Photo 1 of 1 : SP_2019_NA0010_137_60_20190429_00046.jpg

LM Start	10.44	Rating **	U	Issue No.	60
LM End	15.30	Issue Type +	Ma	Location *	LS
Category	Earthen Levee			GPS Latitude/Longitude	
				Start	End
Item	Vegetation			36.834033 °	36.774046 °
				-120.305129 °	-120.285545 °
DWR ID	DWR_NA0010_18_s_2019_60				
Comment Code					
V1 : Control annual grass and weeds on the levee slopes and easements.					
Inspector Comment

View of landside slope looking upstream. (spring 2019)

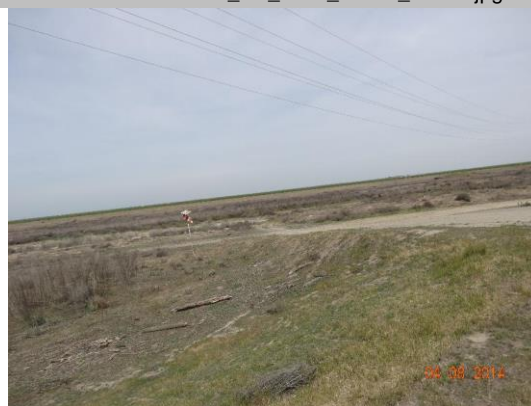
Photo 1 of 3 : UCIP_SP_2019_39505_67226.jpg

LM Start	13.59	Rating **	M	Issue No.	76
LM End	13.59	Issue Type +	En	Location *	
Category	Supplemental			GPS Latitude/Longitude	
				Start	End
Item	DWR UCIP Field Study			36.792684 °	36.792684 °
				-120.304542 °	-120.304542 °
DWR ID	19932				
Comment Code					
Inspector Comment					
FS_ID:39505 DS_ID:19932 EP_NO: N/A Repair Type: Non-Urgent Crossing Status: Indicator Found UCIP Comments: 04/08/2014 Multiple markers visible along waterward and landward sides unable to confirm how many crossings go through levee. Need to contact owner to obtain additional details on crossings. (DWR UCIP - O. Magana) FIELD_STRUCT_DESC: 6-inch natural gas pipeline of an unknown material through the levee. Pipeline extends underneath the channel. [Additional Reference(s): DWR Levee Log, 2002]. FS Date: 4/8/2014

Markers visible on waterward side.

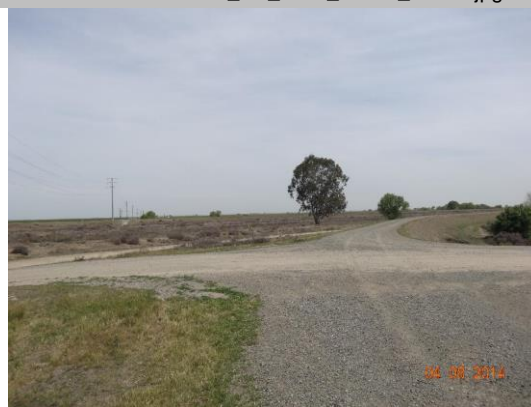
Photo 2 of 3 : UCIP_SP_2019_39505_67225.jpg

View of levee crown at crossing.

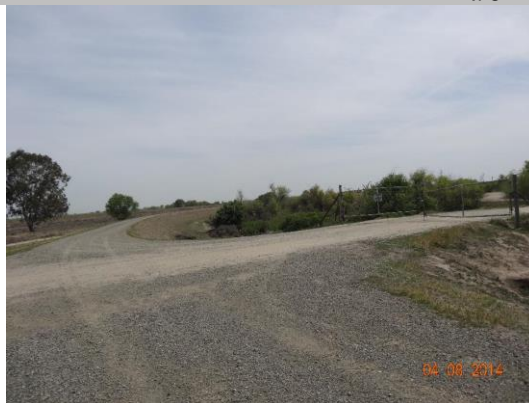
Photo 3 of 3 : UCIP_SP_2019_39505_67224.jpg

LM Start	13.59	Rating **	M	Issue No.	76 (cont)	
LM End	13.59	Issue Type +	En	Location *		
Category	Supplemental			GPS Latitude/Longitude		
				Start		End
Item	DWR UCIP Field Study			36.792684 °		36.792684 °
				-120.304542 °		-120.304542 °
DWR ID	19932					
Comment Code						
Inspector Comment						
FS_ID:39505 DS_ID:19932 EP_NO: N/A Repair Type: Non-Urgent Crossing Status: Indicator Found UCIP Comments: 04/08/2014 Multiple markers visible along waterward and landward sides unable to confirm how many crossings go through levee. Need to contact owner to obtain additional details on crossings. (DWR UCIP - O. Magana) FIELD_STRUCT_DESC: 6-inch natural gas pipeline of an unknown material through the levee. Pipeline extends underneath the channel. [Additional Reference(s): DWR Levee Log, 2002]. FS Date: 4/8/2014

Ramp visible on landward side.

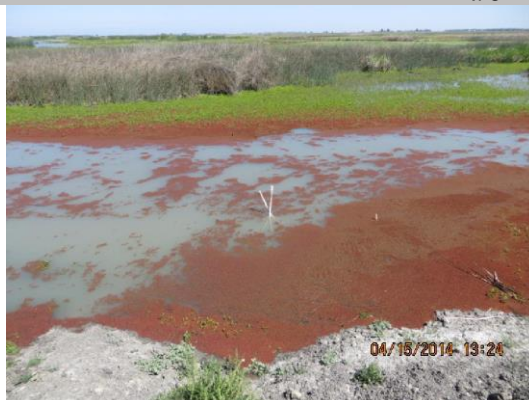
Photo 1 of 3 : UCIP_SP_2019_49959_61060.jpg

Comment Code					
Inspector Comment					
FS_ID:49959					
DS_ID:19933					
EP_NO: N/A					
Repair Type: Non-Urgent					
Crossing Status: Found					
UCIP Comments: 07/19/2016 Gate inside riser appears operable--riser lid damage. Crossing is not visible on LS due to dense vegetation. Recommend clearing dense vegetation along WS and LS slope and repairing riser cover. (DWR UCIP - omagana)04/15/2014 No actuator wheel on slide gate at WS shoulder. (DWR UCIP - wwylie)					
FIELD_STRUCT_DESC: 24-inch corrugated metal gravity drainage pipe through the levee, 14.8 feet below the crown. Slide gate in a 36-inch corrugated metal pipe (CMP) riser on the waterside (WS) slope. Concrete U-shaped headwall on each end. [Additional Reference(s): DWR Levee Log, 2002. USACE San Joaquin O&M Manual 601.1, 1967, (HLM 0.10)].					
FS Date: 7/19/2016

PVC pipes sticking up out of channel likely indicate pipe location on WS toe.

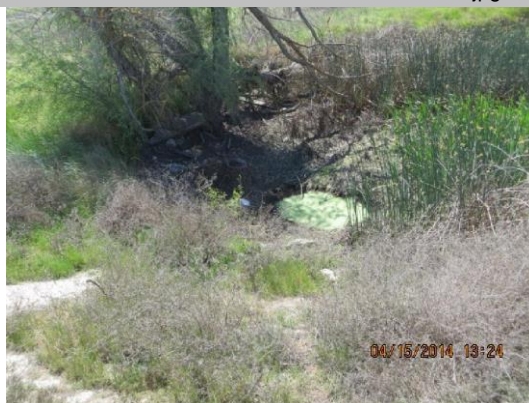
Photo 2 of 3 : UCIP_SP_2019_49959_61061.jpg

Concrete headwall at toe of LS slope.

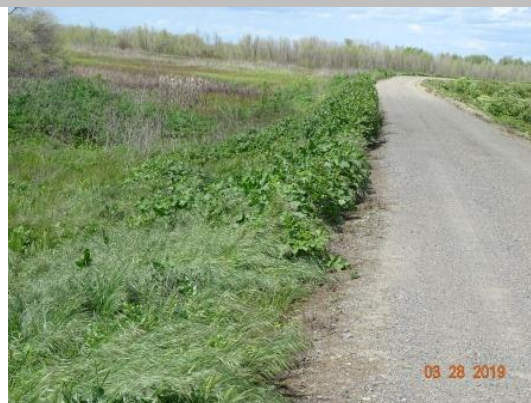
Photo 1 of 1 : SP_2019_NA0010_138_10_20190418_00049.jpg

LM Start	0.11	Rating **	U	Issue No.	10
LM End	5.43	Issue Type +	Ma	Location *	LS
Category	Earthen Levee			GPS Latitude/Longitude	
				Start	End
Item	Vegetation			37.207149 °	37.271517 °
				-120.696305 °	-120.740935 °
DWR ID	DWR_NA0010_22A_s_2019_10				
Comment Code					
V1 : Control annual grass and weeds on the levee slopes and easements.					
Inspector Comment

Representative view of vegetation along landside slope. (Spring 2019)

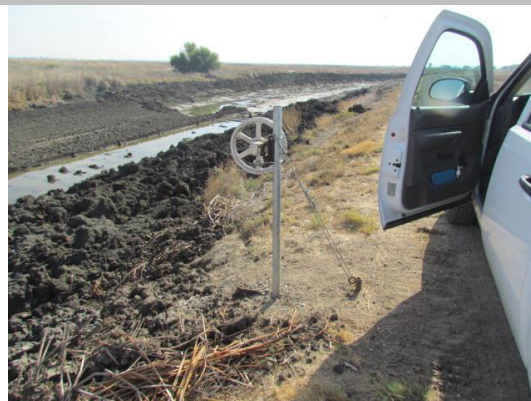
Photo 1 of 1 : SP_2019_NA0010_138_23_20190307_00022.jpg

LM Start	0.87	Rating **	M	Issue No.	23
LM End	0.87	Issue Type +	En	Location *	WS
Category	Earthen Levee			GPS Latitude/Longitude	
				Start	End
Item	Encroachments			37.217802 °	37.217802 °
				-120.697416 °	-120.697416 °
DWR ID	DWR_NA0010_22A_f_2014_23				
Comment Code					
SI : Sign					
Inspector Comment					
A pulley os located on the waterside shoulder without board permit.

Looking south at pulley on waterward shoulder.

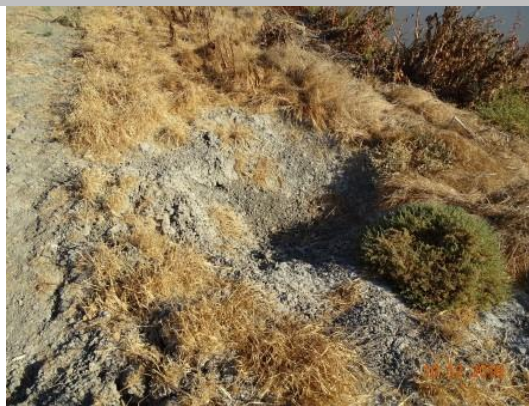
Photo 1 of 1 : SP_2019_NA0010_138_22_20190307_00021.jpg

LM Start	1.04	Rating **	M	Issue No.	22
LM End	1.04	Issue Type +	Ma	Location *	WS
Category	Earthen Levee			GPS Latitude/Longitude	
				Start	End
Item	Erosion / Bank Caving			37.220281 °	37.220281 °
				-120.698287 °	-120.698287 °
DWR ID	DWR_NA0010_22A_f_2018_22				
Comment Code					
E1 : Note and monitor erosion site.					
Inspector Comment					
Depressions are noted on waterside slope.

View of depression on waterside slope. (Fall 2018)

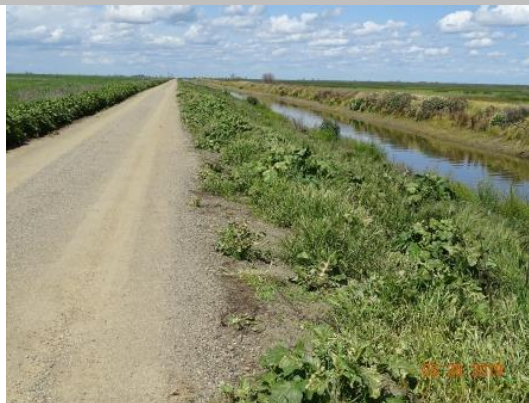
Photo 1 of 1 : SP_2019_NA0010_138_17_20190418_00050.jpg

LM Start	1.05	Rating **	U	Issue No.	17
LM End	1.23	Issue Type +	Ma	Location *	WS
Category	Earthen Levee			GPS Latitude/Longitude	
				Start	End
Item	Vegetation			37.220349 °	37.222864 °
				-120.698310 °	-120.699231 °
DWR ID	DWR_NA0010_22A_s_2019_17				
Comment Code					
V1 : Control annual grass and weeds on the levee slopes and easements.					
Inspector Comment

View of waterside slope looking downstream. (Spring 2019)

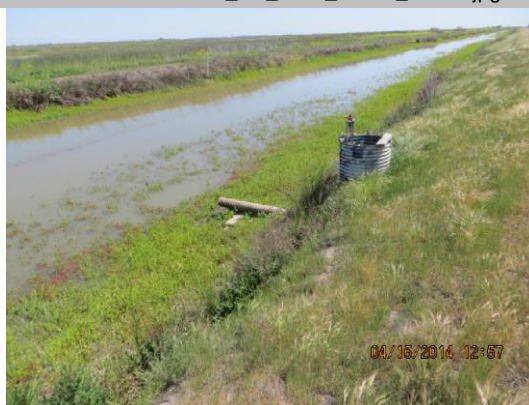
Photo 1 of 3 : UCIP_SP_2019_33733_61030.jpg

Comment Code					
Inspector Comment					
FS_ID:33733 DS_ID:19936 EP_NO: N/A Repair Type: Non-Urgent Crossing Status: Found UCIP Comments: 04/15/2014 Slide gate rusted and does not function. Headwall burried at LS toe. Pipe appears abandoned and if so should be done so properly. (DWR UCIP - W. Wylie) FIELD_STRUCT_DESC: 8-inch corrugated metal gravity irrigation pipe through the levee, 7 feet below the crown. Slide gate in a 36-inch corrugated metal pipe (CMP) riser on the waterside (WS) slope. Concrete headwall on the landside (LS) end. [Additional Reference(s): DWR Levee Log, 2002. USACE San Joaquin O&M Manual 601.1, 1967, (HLM 1.57)]. FS Date: 4/15/2014

Pipe and CMP riser with slide gate visible on WS slope.

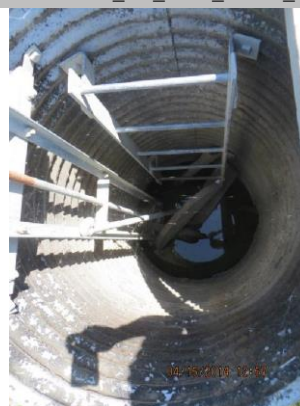
Photo 2 of 3 : UCIP_SP_2019_33733_61029.jpg

Comment Code						
Inspector Comment						
FS_ID:33733 DS_ID:19936 EP_NO: N/A Repair Type: Non-Urgent Crossing Status: Found UCIP Comments: 04/15/2014 Slide gate rusted and does not function. Headwall burried at LS toe. Pipe appears abandoned and if so should be done so properly. (DWR UCIP - W. Wylie) FIELD_STRUCT_DESC: 8-inch corrugated metal gravity irrigation pipe through the levee, 7 feet below the crown. Slide gate in a 36-inch corrugated metal pipe (CMP) riser on the waterside (WS) slope. Concrete headwall on the landside (LS) end. [Additional Reference(s): DWR Levee Log, 2002. USACE San Joaquin O&M Manual 601.1, 1967, (HLM 1.57)]. FS Date: 4/15/2014

Inside CMP riser on WS shoulder.

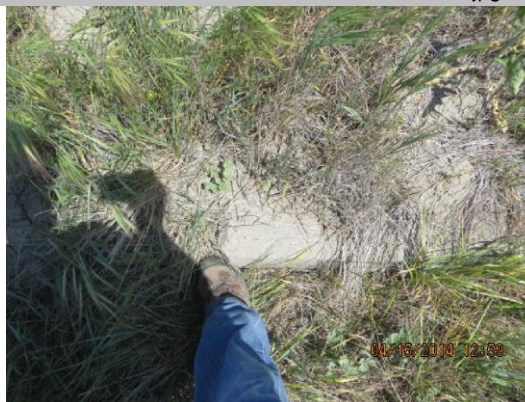
Photo 3 of 3 : UCIP_SP_2019_33733_61028.jpg

Burried concrete headwall on LS toe.

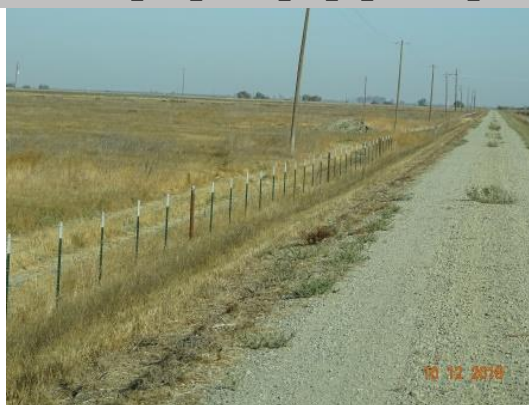
Photo 1 of 1 : SP_2019_NA0010_138_28_20190307_00024.jpg

LM Start	1.75	Rating **	M	Issue No.	28
LM End	2.60	Issue Type +	En	Location *	LS
Category	Earthen Levee			GPS Latitude/Longitude	
				Start	End
Item	Encroachments			37.230585 °	37.242371 °
				-120.702045 °	-120.706371 °
DWR ID	DWR_NA0010_22A_f_2018_28				
Comment Code					
FE : Fence					
Inspector Comment					
A fence is located along the landside toe.

View of fence along landside toe. (Fall 2018)

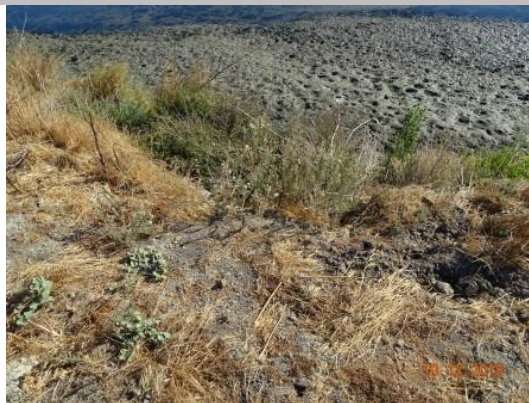
Photo 1 of 2 : SP_2019_NA0010_138_29_20190307_00025.jpg

LM Start	2.20	Rating **	M	Issue No.	29
LM End	2.37	Issue Type +	Ma	Location *	WS
Category	Earthen Levee			GPS Latitude/Longitude	
				Start	End
Item	Erosion / Bank Caving			37.236392 °	37.238776 °
				-120.704165 °	-120.705028 °
DWR ID	DWR_NA0010_22A_f_2018_29				
Comment Code					
E1 : Note and monitor erosion site.					
Inspector Comment					
There is slope erosion from livestock, the slope is no longer 3:1.

View of waterside slope from levee crown. (Fall 2018)

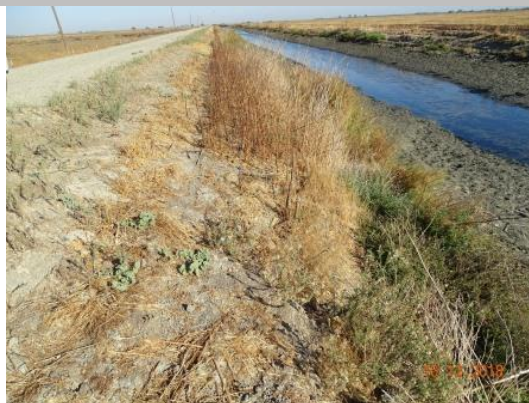
Photo 2 of 2 : SP_2019_NA0010_138_29_20190307_00026.jpg

Looking downstream along waterside slope. (Fall 2018)

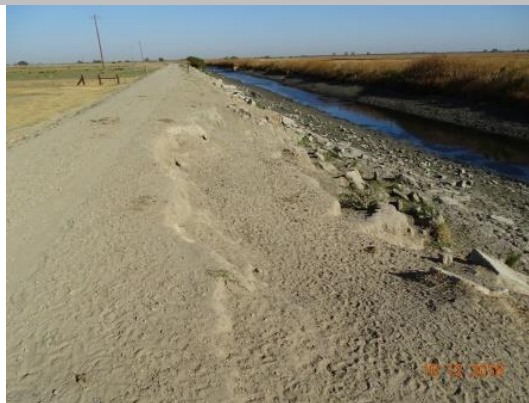
Photo 1 of 3 : SP_2019_NA0010_138_7_20190307_00005.jpg

LM Start	2.65	Rating **	U	Issue No.	7
LM End	2.65	Issue Type +	Ma	Location *	WS
Category	Earthen Levee			GPS Latitude/Longitude	
				Start	End
Item	Erosion / Bank Caving			37.242595 °	37.242595 °
				-120.706470 °	-120.706470 °
DWR ID	DWR_NA0010_22A_s_2017_7				
Comment Code					
E2 : Schedule repair of erosion site prior to the next inspection.					
Inspector Comment					
Erosion is cutting into the crown.

Looking downstream and erosion in waterside slope and shoulder. (Fall 2018)

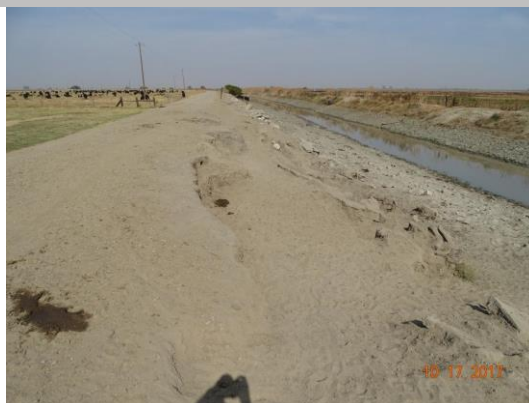
Photo 2 of 3 : SP_2019_NA0010_138_7_20190307_00006.jpg

Looking northwest at the waterside shoulder. (Fall 2017)

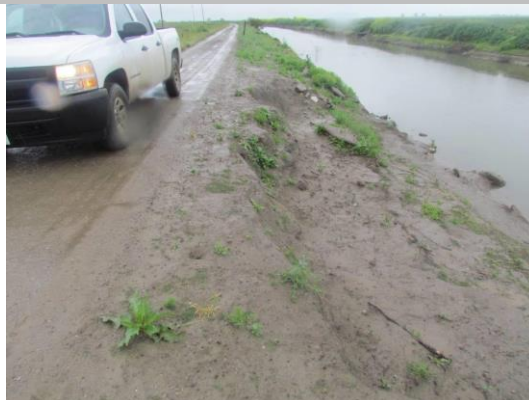
Photo 3 of 3 : SP_2019_NA0010_138_7_20190307_00007.jpg

Looking downstream at erosion on waterward shoulder and slope.
