**Flood Control Project Maintenance
Levee Inspections**
LMA District Cover Sheet
Spring 2019 Levee Inspection Results

Lower San Joaquin Levee District

Spring 2019 Levee Inspection Results

Waterway			Bank	Unit Miles
Unit No. 01 San Joaquin River			Right	22.52
	Spring (March - May)	Summer (June - August)	(September - November) Fall	Winter (December - February)
Unit Maintenance Rating (Fall Only)				
Date of Inspection	3/26/2019 - 3/26/2019			
DWR Inspector	Corey Fujitani			
Accompanied By

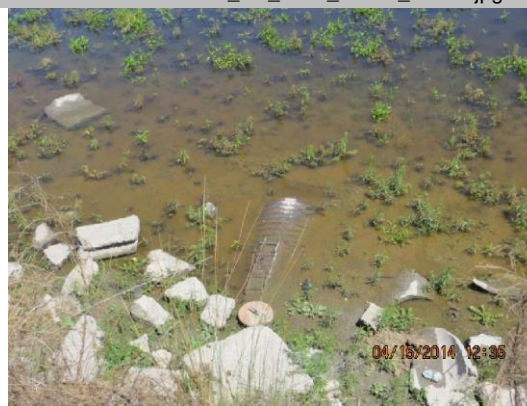
Photo 3 of 3 : UCIP_SP_2019_33732_61025.jpg

LM Start	2.71	Rating **	M	Issue No.	262 (cont)	
LM End	2.71	Issue Type +	En	Location *		
Category	Supplemental			GPS Latitude/Longitude		
				Start	End	
Item	DWR UCIP Field Study			37.243501 °	37.243501 °	
				-120.706773 °	-120.706773 °	
DWR ID	19937					
Comment Code						
Inspector Comment						
FS_ID:33732 DS_ID:19937 EP_NO: N/A Repair Type: Non-Urgent Crossing Status: Found UCIP Comments: 04/15/2014 Slide gate does not function and should be repaired. Headwall at LS toe not found. (DWR UCIP - W. Wylie) FIELD_STRUCT_DESC: 24-inch corrugated metal irrigation siphon pipe through the levee, 7.5 feet below the crown. Slide gate in a 36-inch corrugated metal pipe (CMP) riser on the waterside (WS) slope. Concrete U-shaped headwall on the landside (LS) end. [Additional Reference(s): DWR Levee Log, 2002. USACE San Joaquin O&M Manual 601.1, 1967, (HLM 2.72)]. FS Date: 4/15/2014

Pipe visible on WS toe.

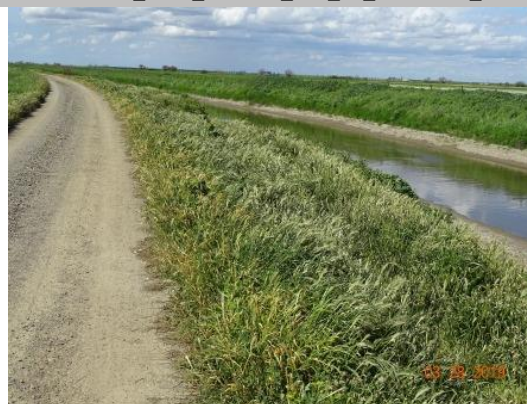
Photo 1 of 1 : SP_2019_NA0010_138_38_20190418_00051.jpg

LM Start	2.81	Rating **	U	Issue No.	38
LM End	3.78	Issue Type +	Ma	Location *	WS
Category	Earthen Levee			GPS Latitude/Longitude	
				Start	End
Item	Vegetation			37.244756 °	37.254845 °
				-120.707371 °	-120.719719 °
DWR ID	DWR_NA0010_22A_s_2019_38				
Comment Code					
V1 : Control annual grass and weeds on the levee slopes and easements.					
Inspector Comment

View of waterside slope looking downstream. (Spring 2019)

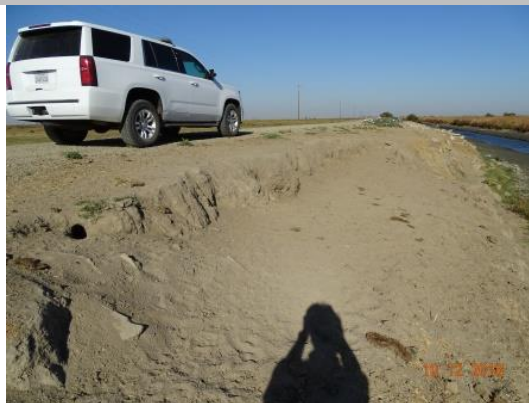
Photo 1 of 2 : SP_2019_NA0010_138_30_20190307_00027.jpg

LM Start	2.82	Rating **	U	Issue No.	30
LM End	2.83	Issue Type +	Ma	Location *	WS
Category	Earthen Levee			GPS Latitude/Longitude	
				Start	End
Item	Erosion / Bank Caving			37.244940 °	37.245050 °
				-120.707467 °	-120.707567 °
DWR ID	DWR_NA0010_22A_f_2018_30				
Comment Code					
E2 : Schedule repair of erosion site prior to the next inspection.					
Inspector Comment					
Erosion is cutting into the waterside bank.

View of erosion in waterside slope. (Fall 2018)

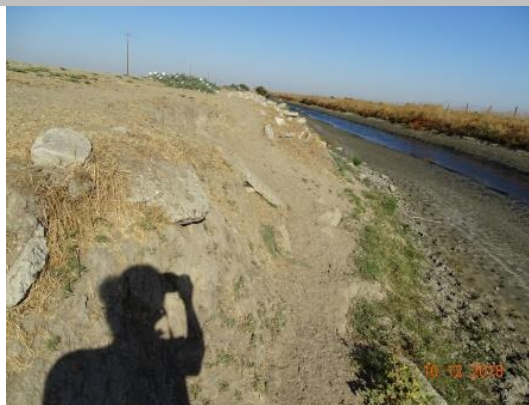
Photo 2 of 2 : SP_2019_NA0010_138_30_20190307_00028.jpg

View along waterside slope. (Fall 2018)

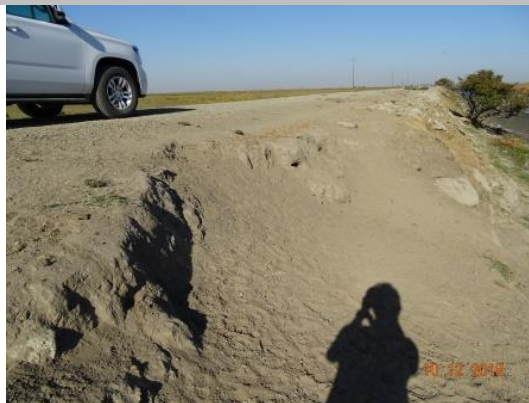
Photo 1 of 1 : SP_2019_NA0010_138_31_20190307_00029.jpg

LM Start	2.87	Rating **	U	Issue No.	31
LM End	2.87	Issue Type +	Ma	Location *	WS
Category	Earthen Levee			GPS Latitude/Longitude	
				Start	End
Item	Erosion / Bank Caving			37.245536 °	37.245536 °
				-120.708119 °	-120.708119 °
DWR ID	DWR_NA0010_22A_f_2018_31				
Comment Code					
E1 : Note and monitor erosion site.					
Inspector Comment					
Erosion is cutting into the waterside shoulder.

View of waterside slope looking downstream. (Fall 2018)

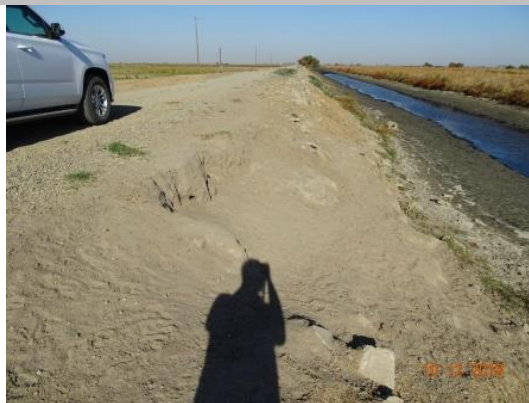
Photo 1 of 1 : SP_2019_NA0010_138_32_20190307_00030.jpg

LM Start	2.96	Rating **	U	Issue No.	32
LM End	2.96	Issue Type +	Ma	Location *	WS
Category	Earthen Levee			GPS Latitude/Longitude	
				Start	End
Item	Erosion / Bank Caving			37.246408 °	37.246408 °
				-120.709197 °	-120.709197 °
DWR ID	DWR_NA0010_22A_f_2018_32				
Comment Code					
E1 : Note and monitor erosion site.					
Inspector Comment					
Erosion is cutting into the waterside slope.

View of waterside slope erosion. (Fall 2018)

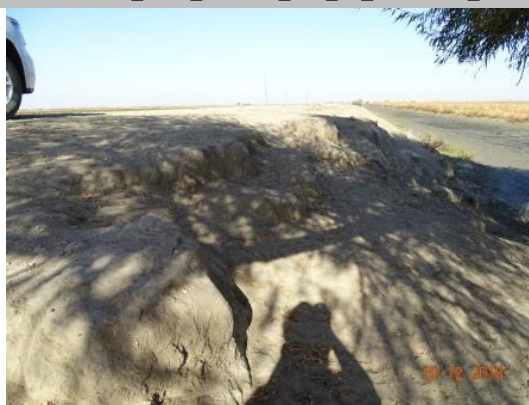
Photo 1 of 1 : SP_2019_NA0010_138_33_20190307_00031.jpg

LM Start	3.14	Rating **	U	Issue No.	33
LM End	3.14	Issue Type +	Ma	Location *	WS
Category	Earthen Levee			GPS Latitude/Longitude	
				Start	End
Item	Erosion / Bank Caving			37.248257 °	37.248257 °
				-120.711547 °	-120.711547 °
DWR ID	DWR_NA0010_22A_f_2018_33				
Comment Code					
E1 : Note and monitor erosion site.					
Inspector Comment					
Erosion is cutting into the waterside slope.

Looking downstream along waterside slope. (Fall 2018)

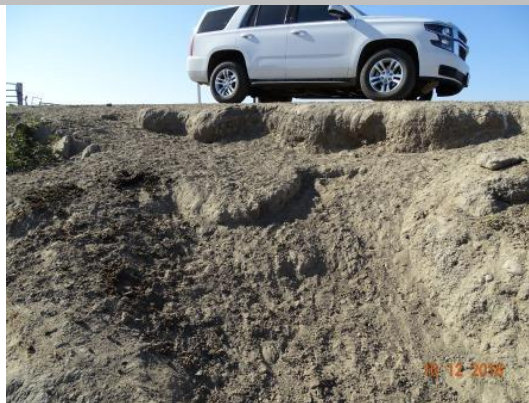
Photo 1 of 1 : SP_2019_NA0010_138_34_20190307_00032.jpg

LM Start	3.44	Rating **	U	Issue No.	34
LM End	3.44	Issue Type +	Ma	Location *	WS
Category	Earthen Levee			GPS Latitude/Longitude	
				Start	End
Item	Erosion / Bank Caving			37.251370 °	37.251370 °
				-120.715344 °	-120.715344 °
DWR ID	DWR_NA0010_22A_f_2018_34				
Comment Code					
E1 : Note and monitor erosion site.					
Inspector Comment					
Slope erosion is from livestock.

View of erosion on slope looking from waterside toe. (Fall 2018)

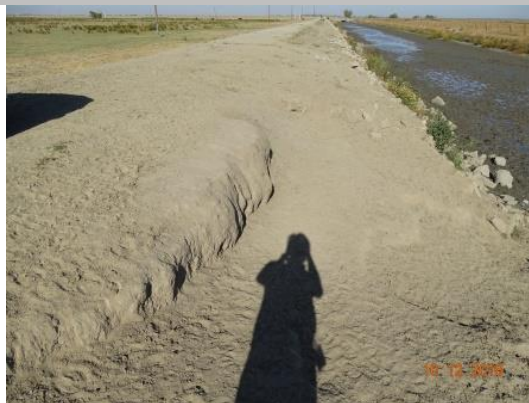
Photo 1 of 1 : SP_2019_NA0010_138_35_20190307_00033.jpg

LM Start	3.47	Rating **	U	Issue No.	35
LM End	3.47	Issue Type +	Ma	Location *	WS
Category	Earthen Levee			GPS Latitude/Longitude	
				Start	End
Item	Erosion / Bank Caving			37.251621 °	37.251621 °
				-120.715649 °	-120.715649 °
DWR ID	DWR_NA0010_22A_f_2018_35				
Comment Code					
E1 : Note and monitor erosion site.					
Inspector Comment					
Waterside slope erosion is from livestock activity.

Erosion in waterside slope from livestock. (Fall 2018)

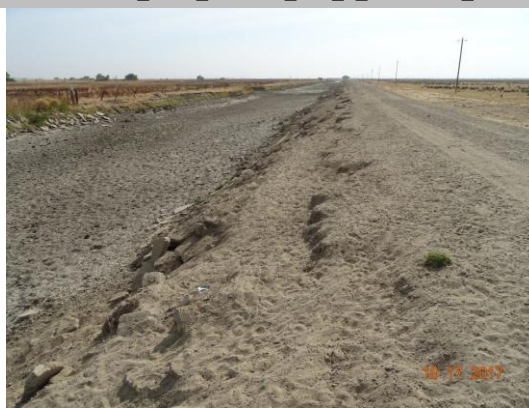
Photo 1 of 2 : SP_2019_NA0010_138_9_20190307_00012.jpg

LM Start	3.64	Rating **	U	Issue No.	9
LM End	3.69	Issue Type +	Ma	Location *	WS
Category	Earthen Levee			GPS Latitude/Longitude	
				Start	End
Item	Erosion / Bank Caving			37.253362 °	37.253862 °
				-120.717873 °	-120.718507 °
DWR ID	DWR_NA0010_22A_f _ 2016_9				
Comment Code					
E1 : Note and monitor erosion site.					
Inspector Comment					
Several erosion or levee damage sites caused by animal traffic are within this section.

Looking southeast at the waterside slope.

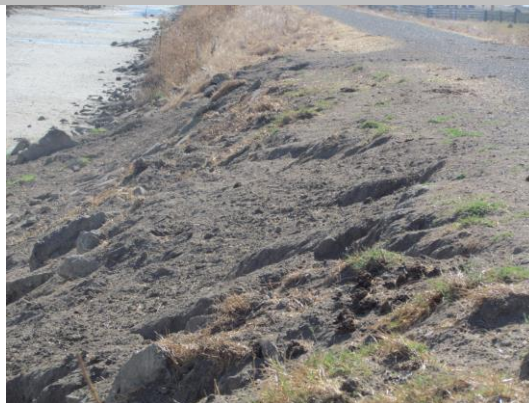
Photo 2 of 2 : SP_2019_NA0010_138_9_20190307_00013.jpg

Looking downstream at animal erosion on waterward slope.

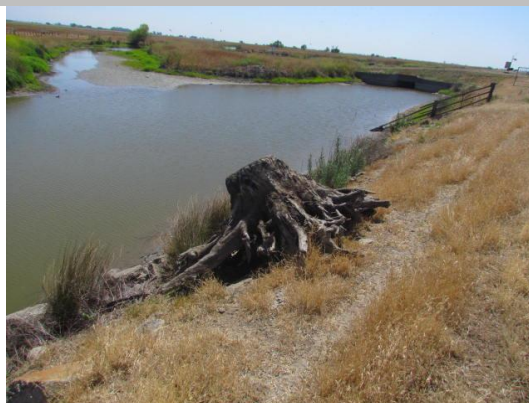
Photo 1 of 1 : SP_2019_NA0010_138_259_20190307_00035.jpg

LM Start	3.80	Rating **	M	Issue No.	259
LM End	3.80	Issue Type +	Ma	Location *	WS
Category	Earthen Levee			GPS Latitude/Longitude	
				Start	End
Item	Encroachments			37.255067 °	37.255067 °
				-120.719910 °	-120.719910 °
DWR ID	DWR_NA0010_22A_s_2015_259				
Comment Code					
TR : Tree or limb					
Inspector Comment					
Dead tree stump on waterside slope.

Looking east at dead stump on waterward slope.

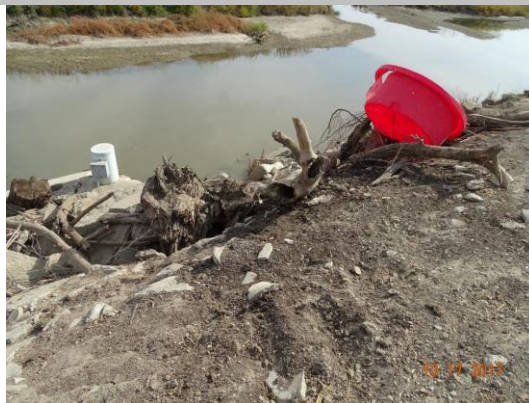
Photo 1 of 1 : SP_2019_NA0010_138_13_20190307_00014.jpg

LM Start	3.81	Rating **	M	Issue No.	13
LM End	3.81	Issue Type +	Ma	Location *	WS
Category	Earthen Levee			GPS Latitude/Longitude	
				Start	End
Item	Encroachments			37.255199 °	37.255199 °
				-120.720094 °	-120.720094 °
DWR ID	DWR_NA0010_22A_f_2017_13				
Comment Code					
TR : Tree or limb					
Inspector Comment

Looking northeast at the waterside slope.

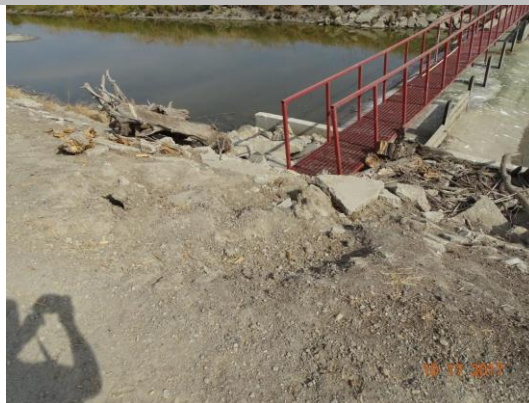
Photo 1 of 1 : SP_2019_NA0010_138_14_20190307_00015.jpg

LM Start	3.82	Rating **	M	Issue No.	14
LM End	3.82	Issue Type +	Ma	Location *	WS
Category	Earthen Levee			GPS Latitude/Longitude	
				Start	End
Item	Slope Stability			37.255239 °	37.255239 °
				-120.720142 °	-120.720142 °
DWR ID	DWR_NA0010_22A_f_2017_14				
Comment Code					
S1 : Repair slope instability.					
Inspector Comment

Looking northeast at the waterside slope. (Fall 2017)

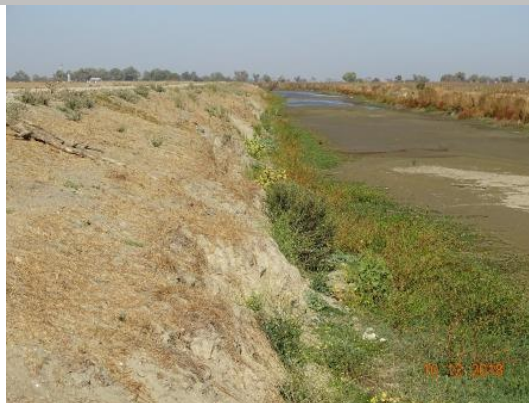
Photo 1 of 1 : SP_2019_NA0010_138_37_20190307_00034.jpg

LM Start	4.28	Rating **	M	Issue No.	37
LM End	5.15	Issue Type +	Ma	Location *	WS
Category	Earthen Levee			GPS Latitude/Longitude	
				Start	End
Item	Erosion / Bank Caving			37.260111 °	37.268533 °
				-120.725900 °	-120.737557 °
DWR ID	DWR_NA0010_22A_f _ 2018_37				
Comment Code					
E1 : Note and monitor erosion site.					
Inspector Comment					
Erosion is cutting into the waterside slope.

View of waterside slope looking downstream. (Fall 2018)

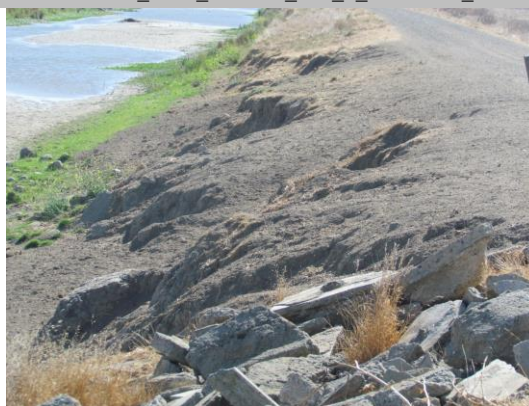
Photo 4 of 4 : SP_2019_NA0010_138_8_20190307_00011.jpg

LM Start	4.87	Rating **	A/W	Issue No.	8 (cont)	
LM End	4.87	Issue Type +	Ma	Location *	WS	
Category	Earthen Levee			GPS Latitude/Longitude		
				Start		End
Item	Slope Stability			37.265813 °		37.265813 °
				-120.733748 °		-120.733748 °
DWR ID	DWR_NA0010_22A_f_2016_8					
Comment Code						
S1 : Repair slope instability.						
Inspector Comment						
Levee damage caused by animal traffic. Several sites repaired with broken concrete.

Looking downstream at animal erosion on waterward slope.

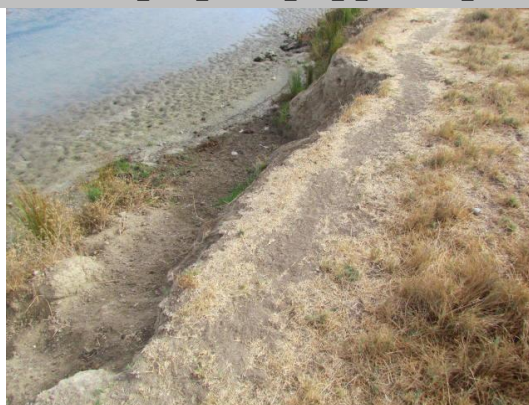
Photo 1 of 2 : SP_2019_NA0010_138_4_20190307_00001.jpg

LM Start	5.05	Rating **	M	Issue No.	4
LM End	5.05	Issue Type +	Ma	Location *	WS
Category	Earthen Levee			GPS Latitude/Longitude	
				Start	End
Item	Erosion / Bank Caving			37.267516 °	37.267516 °
				-120.736401 °	-120.736401 °
DWR ID	DWR_NA0010_22A_f _ 2013_4				
Comment Code					
E2 : Schedule repair of erosion site prior to the next inspection.					
Inspector Comment					
Erosion is caused by animal traffic.

Looking southeast at livestock erosion on waterward toe.

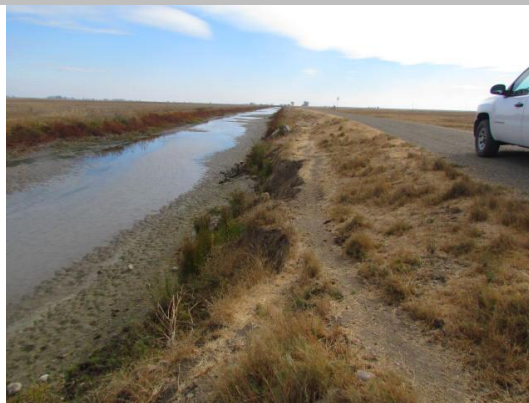
Photo 2 of 2 : SP_2019_NA0010_138_4_20190307_00002.jpg

Looking southeast at livestock erosion on waterward toe.

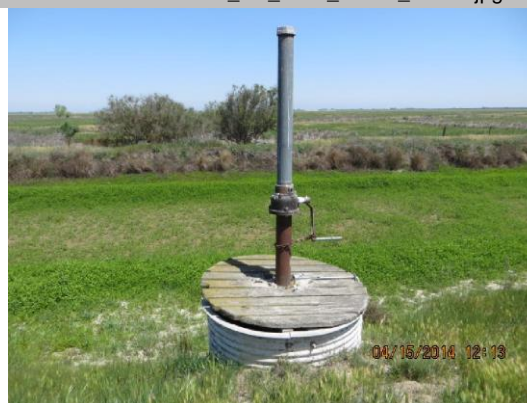
Photo 1 of 3 : UCIP_SP_2019_39536_61022.jpg

Comment Code					
Inspector Comment					
FS_ID:39536 DS_ID:19938 EP_NO: N/A Repair Type: Non-Urgent Crossing Status: Found UCIP Comments: 04/15/2014 Need to contact owner. Pipe silted in on LS toe. Appears abandoned and if so should be done so properly. (DWR UCIP - W. Wylie) FIELD_STRUCT_DESC: 48-inch corrugated metal irrigation siphon pipe through the levee, 10 feet below the crown. Slide gate in a 60-inch corrugated metal pipe (CMP) riser on the waterside (WS) slope. Concrete headwall on the landside (LS) end. WS end capped with a 0.25-inch steel plate. [Additional Reference(s): DWR Levee Log, 2002. USACE San Joaquin O&M Manual 601.1, 1967, (HLM 5.48)]. FS Date: 4/15/2014

Slidegate inside riser on WS shoulder.

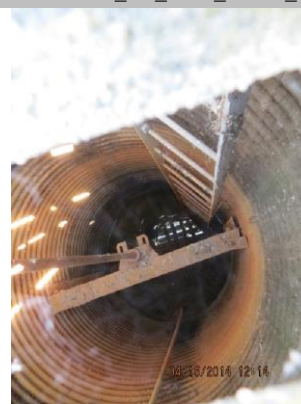
Photo 2 of 3 : UCIP_SP_2019_39536_61021.jpg

Inside riser on WS shoulder.

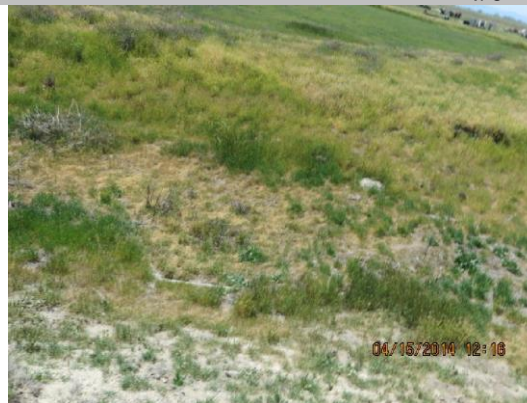
Photo 3 of 3 : UCIP_SP_2019_39536_61020.jpg

Comment Code						
Inspector Comment						
FS_ID:39536 DS_ID:19938 EP_NO: N/A Repair Type: Non-Urgent Crossing Status: Found UCIP Comments: 04/15/2014 Need to contact owner. Pipe silted in on LS toe. Appears abandoned and if so should be done so properly. (DWR UCIP - W. Wylie) FIELD_STRUCT_DESC: 48-inch corrugated metal irrigation siphon pipe through the levee, 10 feet below the crown. Slide gate in a 60-inch corrugated metal pipe (CMP) riser on the waterside (WS) slope. Concrete headwall on the landside (LS) end. WS end capped with a 0.25-inch steel plate. [Additional Reference(s): DWR Levee Log, 2002. USACE San Joaquin O&M Manual 601.1, 1967, (HLM 5.48)]. FS Date: 4/15/2014

Buried headwall on LS toe.

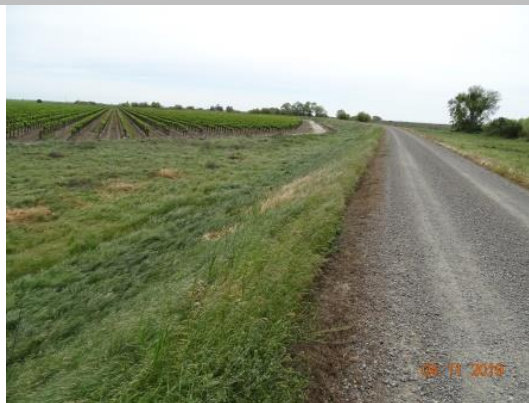
Photo 1 of 1 : SP_2019_NA0010_139_27_20190429_00053.jpg

LM Start	0.00	Rating **	M	Issue No.	27
LM End	3.19	Issue Type +	Ma	Location *	LS
Category	Earthen Levee			GPS Latitude/Longitude	
				Start	End
Item	Vegetation			36.774320 °	36.773021 °
				-120.283697 °	-120.235408 °
DWR ID	DWR_NA0010_23_s_2019_27				
Comment Code					
V1 : Control annual grass and weeds on the levee slopes and easements.					
Inspector Comment

View of landside slope looking upstream. (Spring 2019)

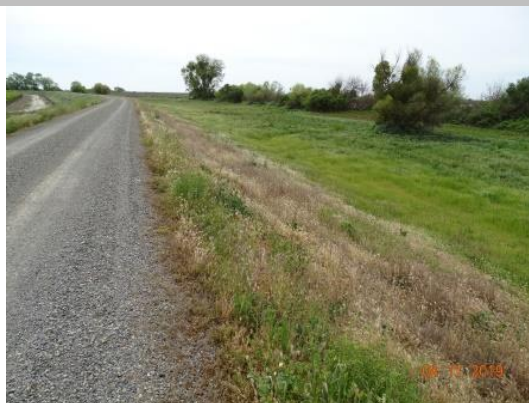
Photo 1 of 1 : SP_2019_NA0010_139_59_20190429_00054.jpg

LM Start	0.00	Rating **	M	Issue No.	59
LM End	6.09	Issue Type +	Ma	Location *	WS
Category	Earthen Levee			GPS Latitude/Longitude	
				Start	End
Item	Vegetation			36.774320 °	36.788892 °
				-120.283697 °	-120.200827 °
DWR ID	DWR_NA0010_23_s_2019_59				
Comment Code					
V1 : Control annual grass and weeds on the levee slopes and easements.					
Inspector Comment

View of waterside slope looking upstream. (Spring 2019)

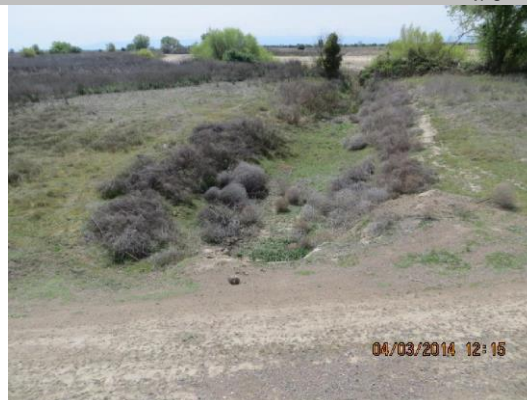
Photo 1 of 3 : UCIP_SP_2019_39537_59860.jpg

Comment Code						
Inspector Comment						
FS_ID:39537 DS_ID:19945 EP_NO: N/A Repair Type: Non-Urgent Crossing Status: Found UCIP Comments: 04/03/2014 Excessive vegetation at inlet--recommend clearing. (DWR UCIP - W. Wylie) FIELD_STRUCT_DESC: 30-inch by 30-inch square reinforced concrete box gravity drainage culvert through the levee, 13 feet below the crown. Flap gate on the waterside (WS) end. Concrete headwall on the landside (LS) end. Concrete U-shaped headwall on the WS end. (Plans to construct a new discharge structure and to rehabilitate one existing diversion structure to return intercepted seepage to the San Joaquin River authorized under Permit No. 13085, 1981 - Diener, Dry River Farms). [Additional Reference(s): DWR Levee Log, 2002. USACE San Joaquin O&M Manual 601.1, 1967, (HLM 0.21)]. FS Date: 4/3/2014

Concrete headwall on WS toe at channel.

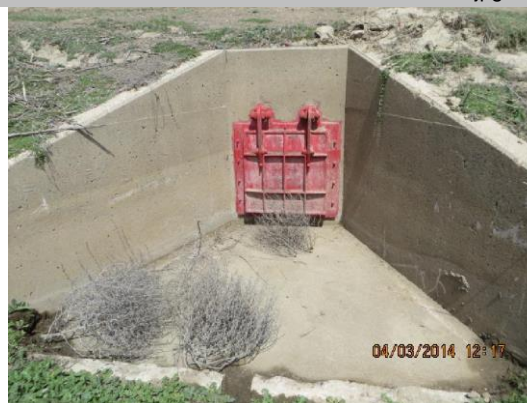
Photo 2 of 3 : UCIP_SP_2019_39537_59859.jpg

Flapgate on Concrete headwall at WS toe.

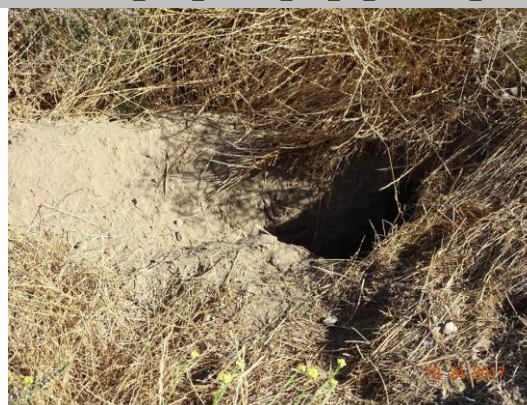
Photo 1 of 1 : SP_2019_NA0010_139_26_20190307_00008.jpg

LM Start	1.09	Rating **	U	Issue No.	26	
LM End	1.09	Issue Type +	Ma	Location *	LS	
Category	Earthen Levee			GPS Latitude/Longitude		
				Start		End
Item	Animal Control			36.772743 °		36.772743 °
				-120.266800 °		-120.266800 °
DWR ID	DWR_NA0010_23_f_2017_26					
Comment Code						
A3 : No rodents visible, but rodent burrows visible; need to backfill and compact or grout burrows.						
Inspector Comment						
Need to repair the large rodent hole on the landside slope.

Looking at the landside slope.

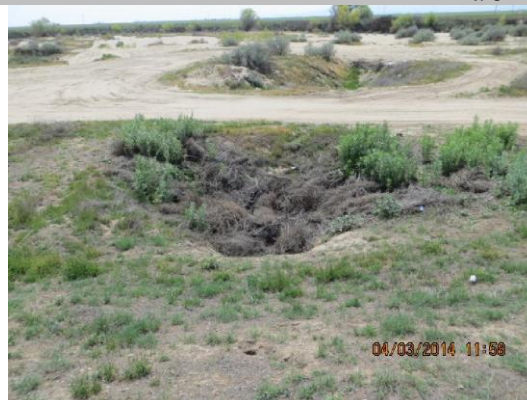
Photo 1 of 3 : UCIP_SP_2019_39538_59855.jpg

Comment Code						
Inspector Comment						
FS_ID:39538 DS_ID:19948 EP_NO: N/A Repair Type: Non-Urgent Crossing Status: Found UCIP Comments: 04/03/2014 Appears abandoned and if so should be done properly. Discharge channel is blocked by sand and soil making drain ineffective. Soil buildup at inlet on LS toe. Need to contact owner. (DWR UCIP - W. Wylie) FIELD_STRUCT_DESC: 30-inch by 30-inch square reinforced concrete box gravity drainage culvert through the levee, 11 feet below the crown. Flap gate on the waterside (WS) end. Concrete headwall on the landside (LS) end. Concrete U-shaped headwall on the WS end. [Additional Reference(s): DWR Levee Log, 2002]. FS Date: 4/3/2014

Concrete headwall on WS toe.

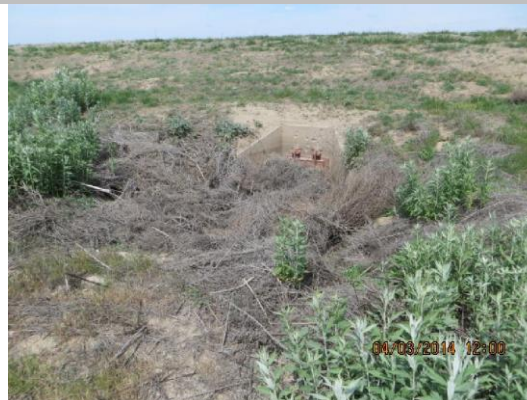
Photo 2 of 3 : UCIP_SP_2019_39538_59857.jpg

Flapgate on Concrete headwall at WS toe.

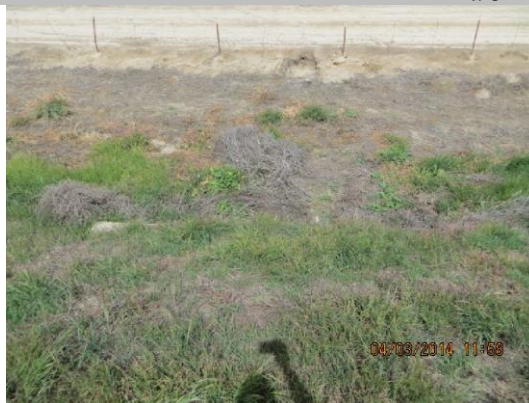
Photo 3 of 3 : UCIP_SP_2019_39538_59856.jpg

Comment Code						
Inspector Comment						
FS_ID:39538 DS_ID:19948 EP_NO: N/A Repair Type: Non-Urgent Crossing Status: Found UCIP Comments: 04/03/2014 Appears abandoned and if so should be done properly. Discharge channel is blocked by sand and soil making drain ineffective. Soil buildup at inlet on LS toe. Need to contact owner. (DWR UCIP - W. Wylie) FIELD_STRUCT_DESC: 30-inch by 30-inch square reinforced concrete box gravity drainage culvert through the levee, 11 feet below the crown. Flap gate on the waterside (WS) end. Concrete headwall on the landside (LS) end. Concrete U-shaped headwall on the WS end. [Additional Reference(s): DWR Levee Log, 2002]. FS Date: 4/3/2014

Concrete headwall on LS toe.

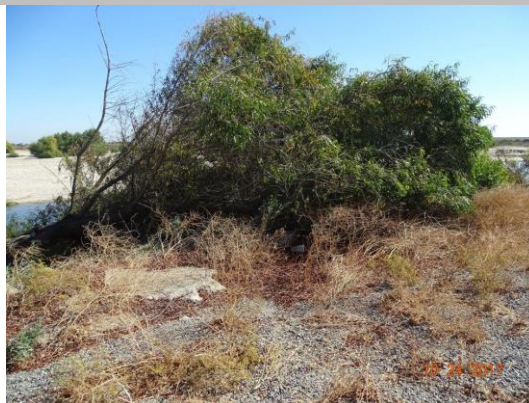
Photo 1 of 1 : SP_2019_NA0010_139_1_20190307_00001.jpg

LM Start	1.91	Rating **	U	Issue No.	1
LM End	1.91	Issue Type +	Ma	Location *	WS
Category	Earthen Levee			GPS Latitude/Longitude	
				Start	End
Item	Encroachments			36.772943 °	36.772943 °
				-120.253511 °	-120.253511 °
DWR ID	DWR_NA0010_23_s_2015_1				
Comment Code					
TR : Tree or limb					
Inspector Comment					
There is a downed tree on the waterside slope.

Looking east at waterside slope.

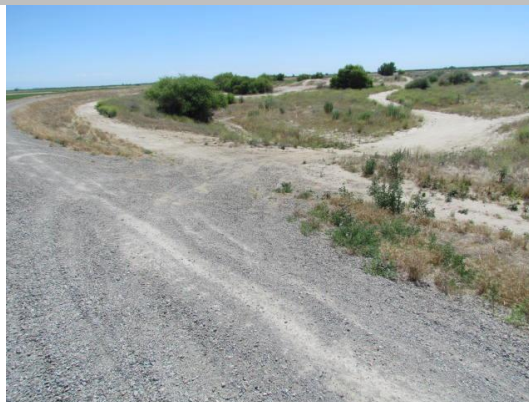
Photo 1 of 1 : SP_2019_NA0010_139_16_20190307_00003.jpg

LM Start	2.12	Rating **	M	Issue No.	16
LM End	2.12	Issue Type +	Ma	Location *	WS
Category	Earthen Levee		GPS Latitude/Longitude		
			Start	End	
Item	Slope Stability		36.775507 °	36.775507 °	
			-120.251670 °	-120.251672 °	
DWR ID	DWR_NA0010_23_s_2013_16				
Comment Code					
S3 : Repair the levee slope damaged by vehicle traffic and prevent access where possible.					
Inspector Comment					
Slope damage is caused by vehicle traffic.

Looking west at one of several damaged slopes cause by vehicle traffic.

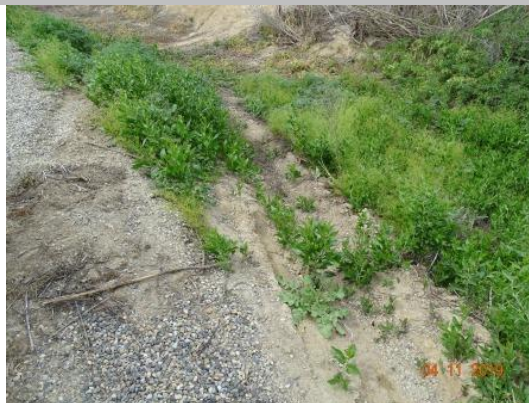
Photo 1 of 2 : SP_2019_NA0010_139_62_20190429_00056.jpg

LM Start	4.85	Rating **	M	Issue No.	62
LM End	4.85	Issue Type +	Ma	Location *	LS
Category	Earthen Levee			GPS Latitude/Longitude	
				Start	End
Item	Slope Stability			36.789489 °	36.789489 °
				-120.220403 °	-120.220403 °
DWR ID	DWR_NA0010_23_s_2019_62				
Comment Code					
S3 : Repair the levee slope damaged by vehicle traffic and prevent access where possible.					
Inspector Comment

View of damage to landside slope by vehicle traffic looking downstream. (Spring 2019)

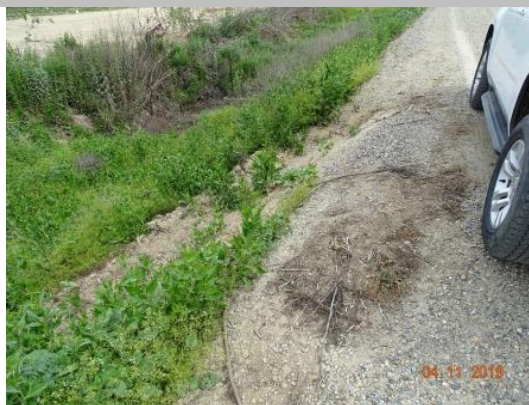
Photo 2 of 2 : SP_2019_NA0010_139_62_20190429_00057.jpg

View of damage to slope looking upstream. (Spring 2019)

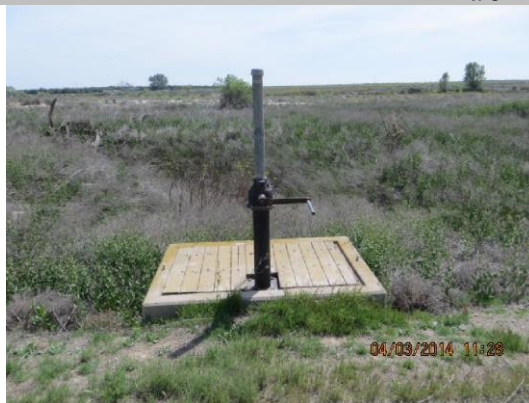
Photo 1 of 3 : UCIP_SP_2019_39540_59848.jpg

LM Start	4.85	Rating **	M	Issue No.	69
LM End	4.85	Issue Type +	En	Location *	
Category	Supplemental			GPS Latitude/Longitude	
				Start	End
Item	DWR UCIP Field Study			36.789550 °	36.789550 °
				-120.220367 °	-120.220367 °
DWR ID	19953				
Comment Code					
Inspector Comment					
FS_ID:39540 DS_ID:19953 EP_NO: N/A Repair Type: Non-Urgent Crossing Status: Found UCIP Comments: 04/03/2014 Heavy vegetation at inlet and outlet--recommend clearing. (DWR UCIP - W. Wylie) FIELD_STRUCT_DESC: 30-inch by 30-inch square reinforced concrete box gravity irrigation culvert through the levee, 10.7 feet below the crown. 4.5-foot by 7-foot concrete riser with slide gate on the waterside (WS) slope. Concrete U-shaped headwall on each end. 15-foot-long cobble revetted inlet channel. [Additional Reference(s): DWR Levee Log, 2002]. FS Date: 4/3/2014

Slide gate in concrete riser on WS shoulder.

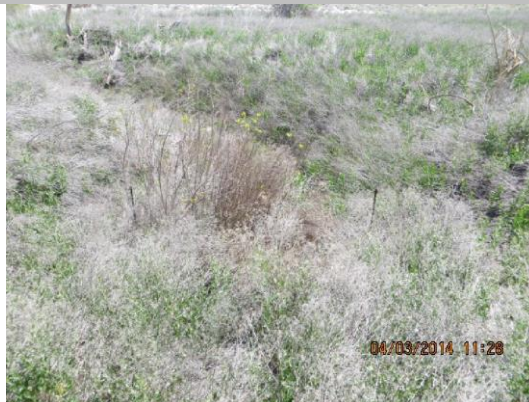
Photo 2 of 3 : UCIP_SP_2019_39540_59847.jpg

Heavy vegetation in outlet/channel on WS toe.

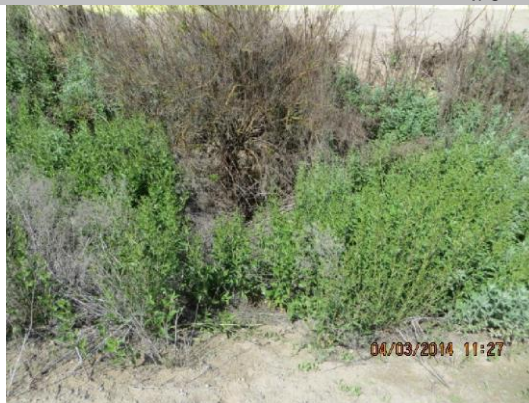
Photo 3 of 3 : UCIP_SP_2019_39540_59849.jpg

LM Start	4.85	Rating **	M	Issue No.	69 (cont)	
LM End	4.85	Issue Type +	En	Location *		
Category	Supplemental			GPS Latitude/Longitude		
				Start		End
Item	DWR UCIP Field Study			36.789550 °		36.789550 °
				-120.220367 °		-120.220367 °
DWR ID	19953					
Comment Code						
Inspector Comment						
FS_ID:39540 DS_ID:19953 EP_NO: N/A Repair Type: Non-Urgent Crossing Status: Found UCIP Comments: 04/03/2014 Heavy vegetation at inlet and outlet--recommend clearing. (DWR UCIP - W. Wylie) FIELD_STRUCT_DESC: 30-inch by 30-inch square reinforced concrete box gravity irrigation culvert through the levee, 10.7 feet below the crown. 4.5-foot by 7-foot concrete riser with slide gate on the waterside (WS) slope. Concrete U-shaped headwall on each end. 15-foot-long cobble revetted inlet channel. [Additional Reference(s): DWR Levee Log, 2002]. FS Date: 4/3/2014

Heavy vegetation at concrete inlet on LS toe.

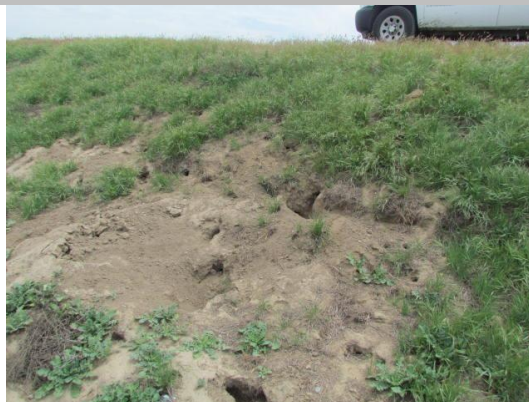
Photo 1 of 1 : SP_2019_NA0010_139_5_20190307_00002.jpg

LM Start	5.68	Rating **	U	Issue No.	5
LM End	5.68	Issue Type +	Ma	Location *	LS
Category	Earthen Levee			GPS Latitude/Longitude	
				Start	End
Item	Animal Control			36.791981 °	36.791981 °
				-120.206274 °	-120.206274 °
DWR ID	DWR_NA0010_23_s_2012_5				
Comment Code					
A1 : Exterminate rodents and backfill and compact or grout burrows.					
Inspector Comment					
There are several large rodent holes in this area.

Looking at several rodent holes on landside slope.

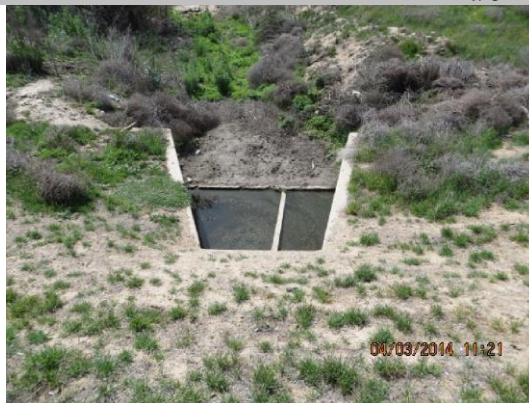
Photo 1 of 3 : UCIP_SP_2019_39542_59830.jpg

Comment Code					
Inspector Comment					
FS_ID:39542 DS_ID:19954 EP_NO: N/A Repair Type: Non-Urgent Crossing Status: Found UCIP Comments: 04/03/2014 Dense vegetation limits the inspector's visibility to identify signs of pipe failure (leaks) along the landward slope. Recommend removing vegetation along pipe alignment to conduct proper inspection of structure. (DWR UCIP - W. Wylie) FIELD_STRUCT_DESC: 36-inch by 36-inch square reinforced concrete box gravity drainage culvert through the levee, 9 feet below the crown. Flap gate on the waterside (WS) end. Concrete U-shaped headwall on each end. 5-foot-long cobble revetted outlet channel. [Additional Reference(s): DWR Levee Log, 2002. USACE San Joaquin O&M Manual 601.1, 1967, (HLM 5.71)]. FS Date: 4/3/2014

Concrete headwall on WS toe.

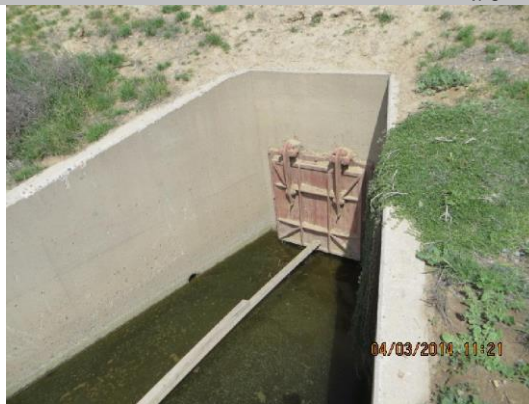
Photo 2 of 3 : UCIP_SP_2019_39542_59829.jpg

Flapgate on Concrete headwall on WS toe.

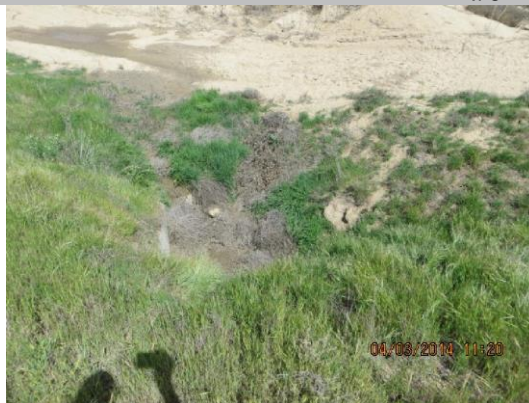
Photo 3 of 3 : UCIP_SP_2019_39542_59831.jpg

Comment Code						
Inspector Comment						
FS_ID:39542						
DS_ID:19954						
EP_NO: N/A						
Repair Type: Non-Urgent						
Crossing Status: Found						
UCIP Comments: 04/03/2014 Dense vegetation limits the inspector's visibility to identify signs of pipe failure (leaks) along the landward slope. Recommend removing vegetation along pipe alignment to conduct proper inspection of structure. (DWR UCIP - W. Wylie)						
FIELD_STRUCT_DESC: 36-inch by 36-inch square reinforced concrete box gravity drainage culvert through the levee, 9 feet below the crown. Flap gate on the waterside (WS) end. Concrete U-shaped headwall on each end. 5-foot-long cobble revetted outlet channel. [Additional Reference(s): DWR Levee Log, 2002. USACE San Joaquin O&M Manual 601.1, 1967, (HLM 5.71)].						
FS Date: 4/3/2014

Concrete headwall at LS toe.

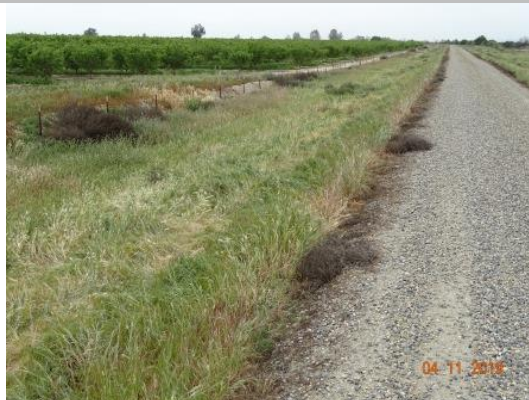
Photo 1 of 1 : SP_2019_NA0010_139_63_20190429_00059.jpg

LM Start	6.09	Rating **	U	Issue No.	63
LM End	9.76	Issue Type +	Ma	Location *	LS
Category	Earthen Levee			GPS Latitude/Longitude	
				Start	End
Item	Vegetation			36.788892 °	36.807942 °
				-120.200827 °	-120.168824 °
DWR ID	DWR_NA0010_23_s_2019_63				
Comment Code					
V1 : Control annual grass and weeds on the levee slopes and easements.					
Inspector Comment

View of landside slope looking upstream. (Spring 2019)

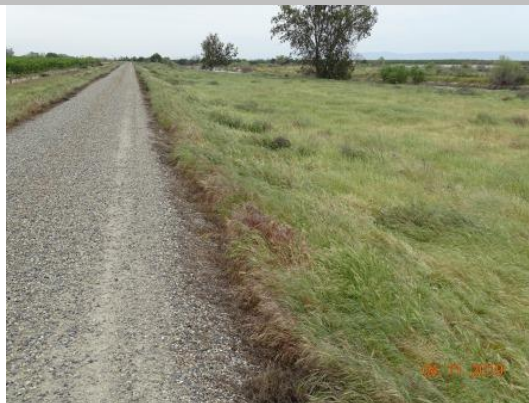
Photo 1 of 1 : SP_2019_NA0010_139_64_20190429_00058.jpg

LM Start	6.09	Rating **	U	Issue No.	64
LM End	9.76	Issue Type +	Ma	Location *	WS
Category	Earthen Levee			GPS Latitude/Longitude	
				Start	End
Item	Vegetation			36.788892 °	36.807942 °
				-120.200827 °	-120.168824 °
DWR ID	DWR_NA0010_23_s_2019_64				
Comment Code					
V1 : Control annual grass and weeds on the levee slopes and easements.					
Inspector Comment

View of waterside slope looking upstream. (Spring 2019)

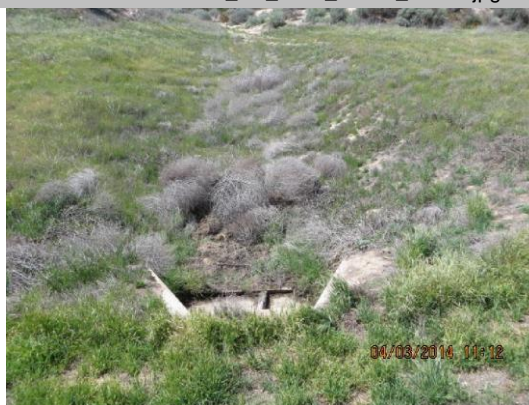
Photo 1 of 3 : UCIP_SP_2019_39543_59826.jpg

Comment Code					
Inspector Comment					
FS_ID:39543 DS_ID:19939 EP_NO: N/A Repair Type: Non-Urgent Crossing Status: Found UCIP Comments: 04/03/2014 Dense vegetation limits the inspector's visibility to identify signs of pipe failure (leaks) along the landward slope. Recommend removing vegetation along pipe alignment to conduct proper inspection of structure. (DWR UCIP - W. Wylie) FIELD_STRUCT_DESC: 30-inch by 30-inch square reinforced concrete box gravity drainage culvert through the levee, 8.5 feet below the crown. Flap gate on the waterside (WS) end. Concrete headwall on the landside (LS) end. Concrete U-shaped headwall on the WS end. [Additional Reference(s): DWR Levee Log, 2002]. FS Date: 4/3/2014

Concrete headwall on WS toe.

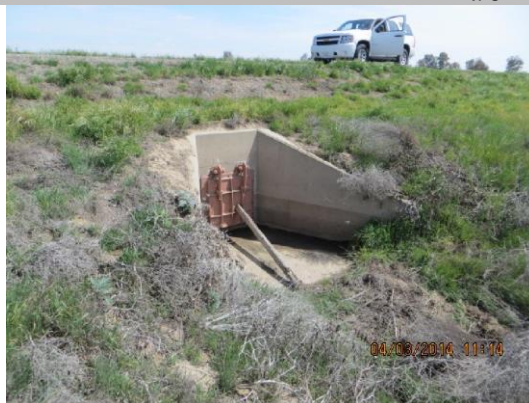
Photo 2 of 3 : UCIP_SP_2019_39543_59828.jpg

Comment Code						
Inspector Comment						
FS_ID:39543						
DS_ID:19939						
EP_NO: N/A						
Repair Type: Non-Urgent						
Crossing Status: Found						
UCIP Comments: 04/03/2014 Dense vegetation limits the inspector's visibility to identify signs of pipe failure (leaks) along the landward slope. Recommend removing vegetation along pipe alignment to conduct proper inspection of structure. (DWR UCIP - W. Wylie)						
FIELD_STRUCT_DESC: 30-inch by 30-inch square reinforced concrete box gravity drainage culvert through the levee, 8.5 feet below the crown. Flap gate on the waterside (WS) end. Concrete headwall on the landside (LS) end. Concrete U-shaped headwall on the WS end. [Additional Reference(s): DWR Levee Log, 2002].						
FS Date: 4/3/2014

Flapgate on Concrete headwall at WS toe.

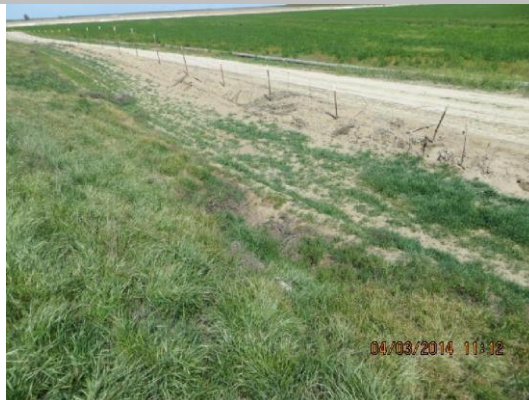
Photo 3 of 3 : UCIP_SP_2019_39543_59827.jpg

Concrete headwall on LS toe.

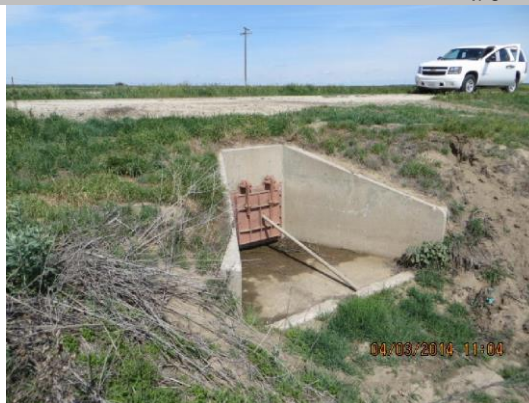
Photo 1 of 3 : UCIP_SP_2019_39544_59823.jpg

Comment Code					
Inspector Comment					
FS_ID:39544 DS_ID:19940 EP_NO: N/A Repair Type: Non-Urgent Crossing Status: Found UCIP Comments: 04/03/2014 Some sediment buildup at inlet at LS toe. Also dense vegetation limits the inspector's visibility to identify signs of pipe failure (leaks) along the landward slope. Recommend removing vegetation along pipe alignment to conduct proper inspection of structure. (DWR UCIP - W. Wylie) FIELD_STRUCT_DESC: 30-inch by 30-inch square reinforced concrete box gravity drainage culvert through the levee, 5.2 feet below the crown. Flap gate on the waterside (WS) end. Concrete headwall on the landside (LS) end. Concrete U-shaped headwall on the WS end. [Additional Reference(s): DWR Levee Log, 2002. USACE San Joaquin O&M Manual 601.1, 1967, (HLM 8.33)]. FS Date: 4/3/2014

Flapgate on WS toe.

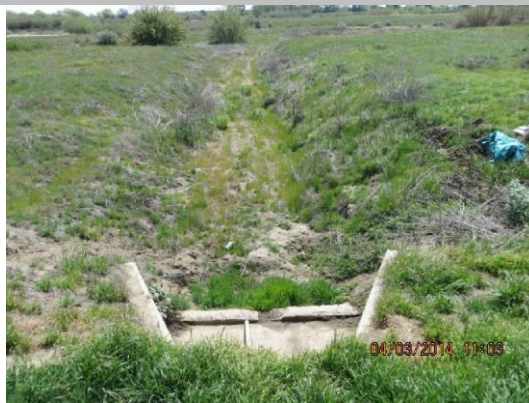
Photo 2 of 3 : UCIP_SP_2019_39544_59821.jpg

concrete headwall at drainage ditch on WS toe.

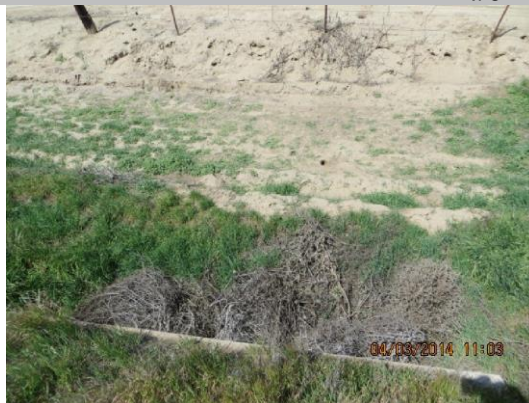
Photo 3 of 3 : UCIP_SP_2019_39544_59822.jpg

Comment Code						
Inspector Comment						
FS_ID:39544 DS_ID:19940 EP_NO: N/A Repair Type: Non-Urgent Crossing Status: Found UCIP Comments: 04/03/2014 Some sediment buildup at inlet at LS toe. Also dense vegetation limits the inspector's visibility to identify signs of pipe failure (leaks) along the landward slope. Recommend removing vegetation along pipe alignment to conduct proper inspection of structure. (DWR UCIP - W. Wylie) FIELD_STRUCT_DESC: 30-inch by 30-inch square reinforced concrete box gravity drainage culvert through the levee, 5.2 feet below the crown. Flap gate on the waterside (WS) end. Concrete headwall on the landside (LS) end. Concrete U-shaped headwall on the WS end. [Additional Reference(s): DWR Levee Log, 2002. USACE San Joaquin O&M Manual 601.1, 1967, (HLM 8.33)]. FS Date: 4/3/2014

Concrete headwall on LS toe.

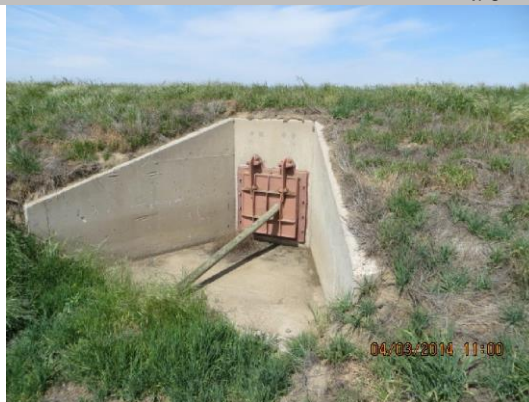
Photo 2 of 3 : UCIP_SP_2019_39545_59819.jpg

Flapgate on Concrete headwall at WS toe.

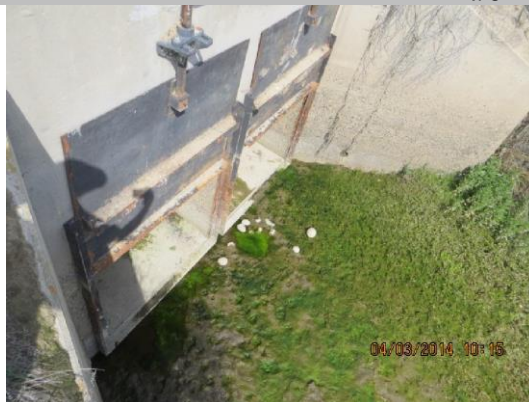
Photo 2 of 3 : UCIP_SP_2019_53192_59809.jpg

Slide gate on concrete headwall at WS toe.

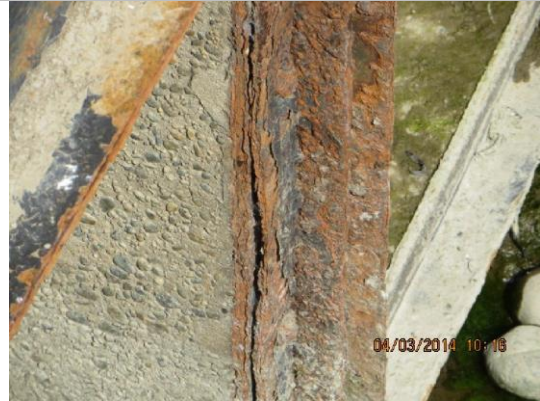
Photo 3 of 3 : UCIP_SP_2019_53193_59800.jpg

Heavy corrosion in slide gate tracks on WS toe.

Comment Code						
Inspector Comment						
FS_ID:53193 DS_ID:19980 EP_NO: N/A Repair Type: Non-Urgent Crossing Status: Found UCIP Comments: 11/01/2018 Limited access to both LS and WS; assumed slide gates are still non-functional; Crossing has been downgraded from Urgent to Non-Urgent due to re-classification of damage slide gates. (O. Magana - DWR UCIP)07/20/2016 No change--same as previous inspection. (DWR UCIP - omagana)04/03/2014 Slide gate not functional. Slide gate channels heavily corroded (exfoliated) and likely impact functionality/structural integrity of gate. (DWR UCIP - wwylie) FIELD_STRUCT_DESC: [Gravelly Ford Canal Irrigation Structure] 2 of 2: 48-inch by 63-inch reinforced concrete box gravity irrigation culvert through the levee, 10 feet below the crown. Concrete U-shaped headwall on each end. Gear pedestal slide gate with wall bracket on the waterside (WS) headwall. 10-foot-long cobble revetted outlet channel. Guardrail on each shoulder. [Additional Reference(s): DWR Levee Log, 2002]. FS Date: 11/1/2018 12:51:00 PM

Slide gate tracks show heavy corrosion impacting actuation of slide gate.

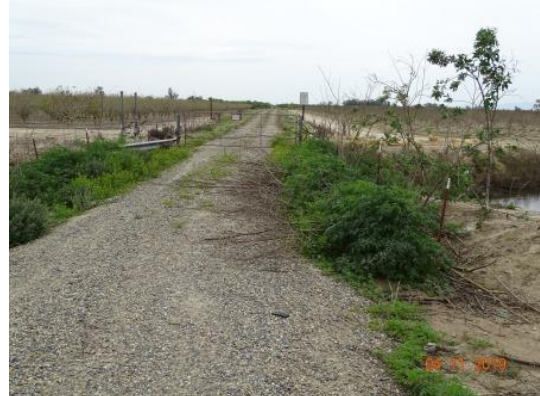
Photo 1 of 3 : SP_2019_NA0010_139_58_20190429_00060.jpg

LM Start	9.79	Rating **	M	Issue No.	58
LM End	9.81	Issue Type +	Ma	Location *	LS
Category	Earthen Levee			GPS Latitude/Longitude	
				Start	End
Item	Trim / Thin Trees			36.808317 °	36.808553 °
				-120.168820 °	-120.168827 °
DWR ID	DWR_NA0010_23_f_2018_58				
Comment Code					
T2 : Thin trees to allow visibility of the ground and room to flood fight.					
Inspector Comment					
Woody vegetation is partially blocking crown and landside slope.

View of woody vegetation on landside shoulder partially blocking access across crown. (Spring 2019)

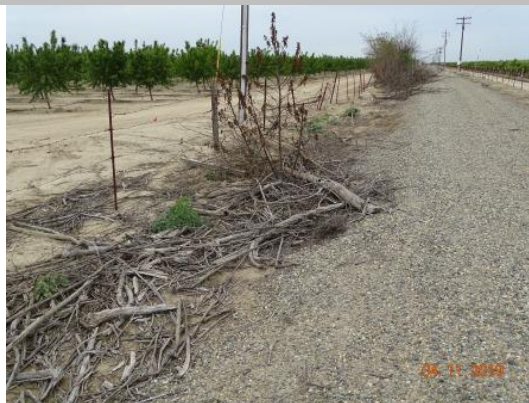
Photo 2 of 3 : SP_2019_NA0010_139_58_20190429_00061.jpg

View of woody vegetation left on landside slope and toe. (Spring 2019)

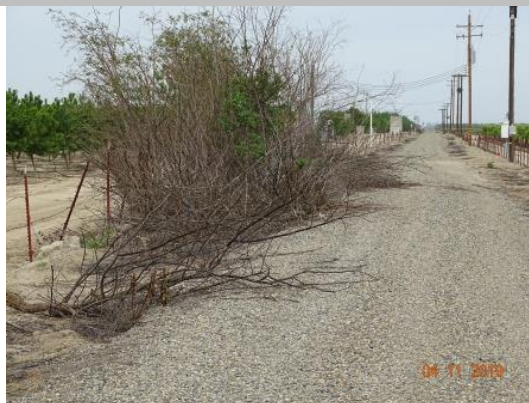
Photo 3 of 3 : SP_2019_NA0010_139_58_20190429_00062.jpg

Woody vegetation on landside toe obstructing landside of crown. (Spring 2019)

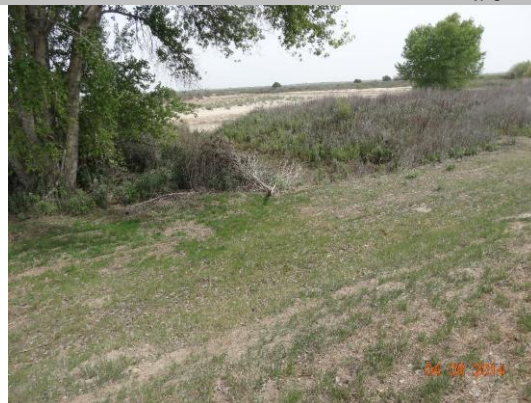
Photo 1 of 3 : UCIP_SP_2019_33264_60059.jpg

LM Start	0.50	Rating **	M	Issue No.	267
LM End	0.50	Issue Type +	En	Location *	
Category	Supplemental			GPS Latitude/Longitude	
				Start	End
Item	DWR UCIP Field Study			36.766872 °	36.766872 °
				-120.283212 °	-120.283212 °
DWR ID	19955				
Comment Code					
Inspector Comment					
FS_ID:33264 DS_ID:19955 EP_NO: N/A Repair Type: Non-Urgent Crossing Status: Found UCIP Comments: 04/08/2014 No access available to confirm condition of landward side headwall. Recommend clearing debris along fence. Surface erosion near concrete headwall on landward side was present. (DWR UCIP - O. Magana) FIELD_STRUCT_DESC: 30-inch by 30-inch square reinforced concrete box gravity drainage culvert through the levee, 13.5 feet below the crown. Flap gate on the waterside (WS) end. Concrete headwall on each end. [Additional Reference(s): DWR Levee Log, 2002]. FS Date: 4/8/2014

View of waterward side.

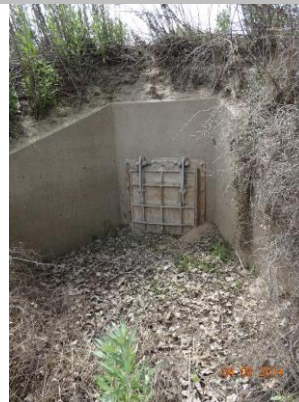
Photo 2 of 3 : UCIP_SP_2019_33264_60057.jpg

Square gate visible on waterward side.

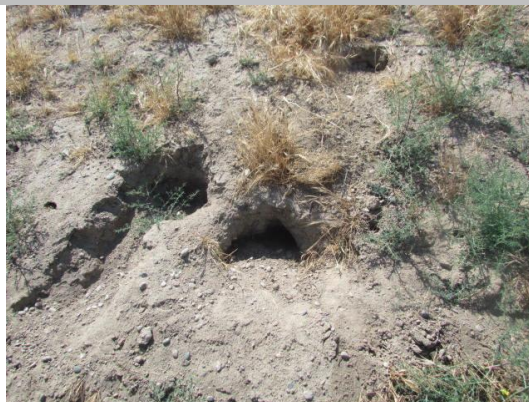
Photo 1 of 1 : SP_2019_NA0010_140_6_20190307_00002.jpg

LM Start	0.82	Rating **	M	Issue No.	6
LM End	0.84	Issue Type +	Ma	Location *	LS
Category	Earthen Levee			GPS Latitude/Longitude	
				Start	End
Item	Animal Control			36.766775 °	36.766962 °
				-120.278757 °	-120.278602 °
DWR ID	DWR_NA0010_24_s_2013_6				
Comment Code					
A1 : Exterminate rodents and backfill and compact or grout burrows.					
Inspector Comment					
There are several rodent holes identified within this section.

Looking at several rodent holes on landward slope.

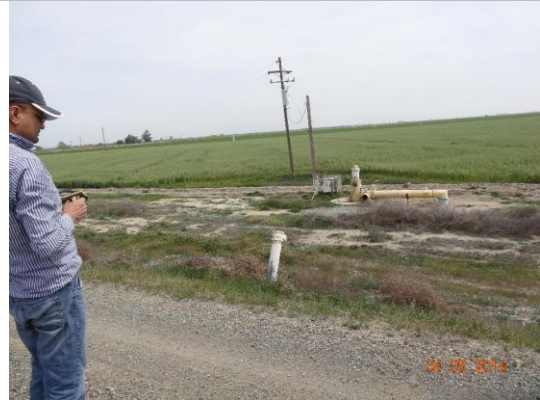
Photo 1 of 2 : UCIP_SP_2019_33265_60065.jpg

Comment Code					
Inspector Comment					
FS_ID:33265					
DS_ID:19961					
EP_NO: 13735					
Repair Type: Non-Urgent					
Crossing Status: Found					
UCIP Comments: 04/08/2014 Unable to determine status of crossing.					
Need to contact owner to determine status of crossing. (DWR UCIP - O. Magana)					
FIELD_STRUCT_DESC: 24-inch coated steel drainage discharge pipe through the levee, 2 feet below the crown. Crown roadway has been padded 1 foot. Steel cutoff wall around the pipe at the centerline of the levee. Pump on the landside (LS). Siphon breaker on the apex of the pipe on the LS shoulder. Galvanized siphon vent pipe on the LS shoulder. (Plans to install two 24-inch steel discharge pipelines through the levee to dispose of seepage water collected in farm sumps Nos. 8 and 12 authorized under Permit No. 13735, 1983 - Rio Seco Farm).					
[Additional Reference(s): DWR Levee Log, 2002].					
FS Date: 4/8/2014

View of landward side.

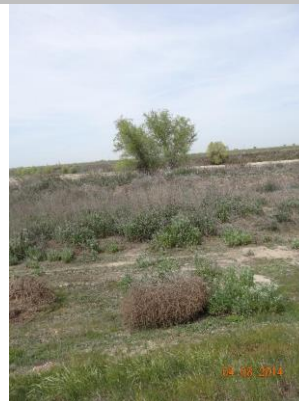
Photo 2 of 3 : UCIP_SP_2019_33266_60070.jpg

View of waterward side.

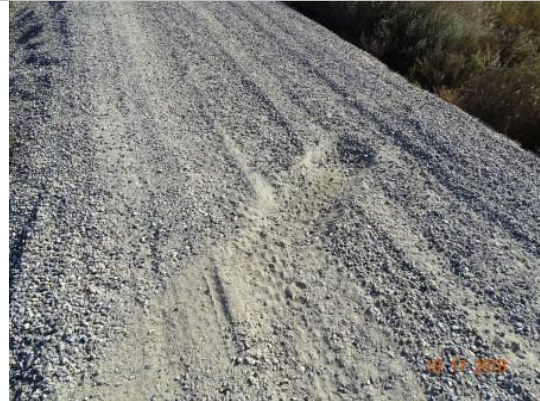
Photo 1 of 1 : SP_2019_NA0010_140_30_20190307_00012.jpg

LM Start	2.52	Rating **	A/W	Issue No.	30
LM End	2.52	Issue Type +	Ma	Location *	CR
Category	Earthen Levee			GPS Latitude/Longitude	
				Start	End
Item	Crown Surface / Depressions / Rutting			36.770298 °	36.770298 °
				-120.253468 °	-120.253468 °
DWR ID	DWR_NA0010_24_f_2018_30				
Comment Code					
C2 : Repair depressions or ruts in the crown or slope.					
Inspector Comment					
There is a depression across the crown of the levee.

View of depression across crown. (Fall 2018)

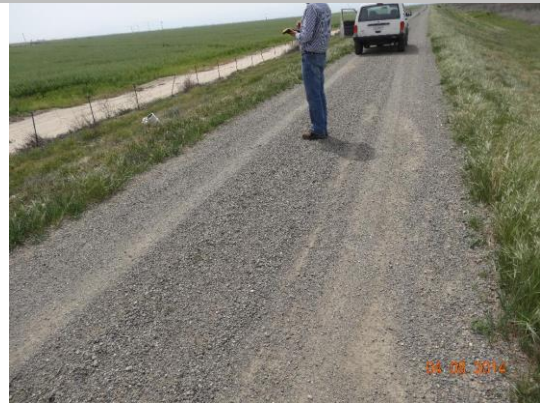
Photo 1 of 3 : UCIP_SP_2019_33267_60075.jpg

Comment Code					
Inspector Comment					
FS_ID:33267 DS_ID:19963 EP_NO: 13735 Repair Type: Non-Urgent Crossing Status: Found UCIP Comments: 04/08/2014 Unable to confirm status of crossing. (DWR UCIP - O. Magana) FIELD_STRUCT_DESC: 24-inch coated steel drainage discharge pipe through the levee, 2 feet below the crown. Crown roadway has been padded 1 foot. Steel cutoff wall around the pipe at the centerline of the levee. Pump on the landside (LS). Siphon breaker on the apex of the pipe on the LS shoulder. Galvanized siphon vent pipe on the LS shoulder. (Plans to install two 24-inch steel discharge pipelines through the levee to dispose of seepage water collected in farm sumps Nos. 8 and 12 authorized under Permit No. 13735, 1983 - Rio Seco Farm). [Additional Reference(s): DWR Levee Log, 2002]. FS Date: 4/8/2014

Overview of levee crown at crossing.

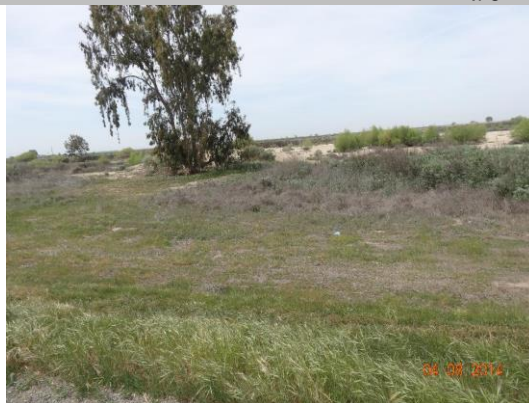
Photo 2 of 3 : UCIP_SP_2019_33267_60076.jpg

View of waterward side.

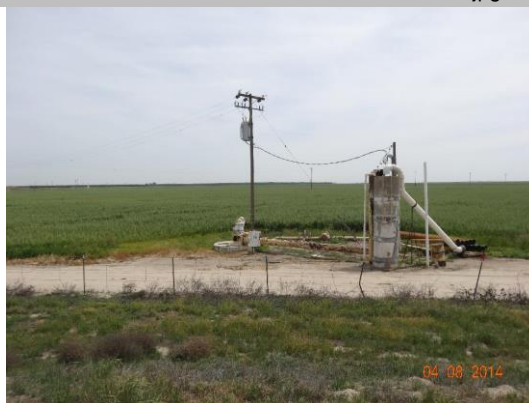
Photo 3 of 3 : UCIP_SP_2019_33267_60077.jpg

View of landward side.

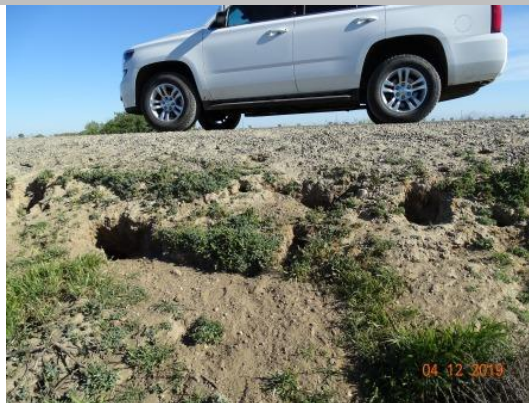
Photo 1 of 1 : SP_2019_NA0010_140_51_20190429_00046.jpg

LM Start	3.05	Rating **	U	Issue No.	51
LM End	3.10	Issue Type +	Ma	Location *	LS
Category	Earthen Levee			GPS Latitude/Longitude	
				Start	End
Item	Animal Control			36.770146 °	36.769966 °
				-120.245703 °	-120.244853 °
DWR ID	DWR_NA0010_24_s_2019_51				
Comment Code					
A3 : No rodents visible, but rodent burrows visible; need to backfill and compact or grout burrows.					
Inspector Comment

View of rodent holes in landside slope. (Spring 2019)
