**Flood Control Project Maintenance
Levee Inspections**
LMA District Cover Sheet
Spring 2019 Levee Inspection Results

Lower San Joaquin Levee District

Spring 2019 Levee Inspection Results

Waterway			Bank	Unit Miles
Unit No. 01 San Joaquin River			Right	22.52
	Spring (March - May)	Summer (June - August)	(September - November) Fall	Winter (December - February)
Unit Maintenance Rating (Fall Only)				
Date of Inspection	3/26/2019 - 3/26/2019			
DWR Inspector	Corey Fujitani			
Accompanied By

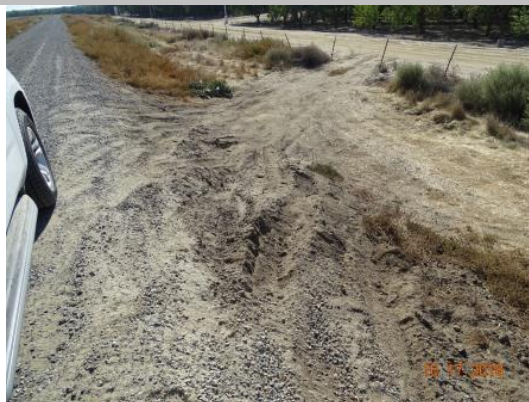
Photo 1 of 1 : SP_2019_NA0010_140_35_20190307_00015.jpg

LM Start	3.53	Rating **	M	Issue No.	35
LM End	3.53	Issue Type +	Ma	Location *	LS
Category	Earthen Levee			GPS Latitude/Longitude	
				Start	End
Item	Slope Stability			36.768873 °	36.768873 °
				-120.237161 °	-120.237161 °
DWR ID	DWR_NA0010_24_f_2018_35				
Comment Code					
S3 : Repair the levee slope damaged by vehicle traffic and prevent access where possible.					
Inspector Comment					
There is vehicle damage to the landside slope. The land owner removed a section of the fence to allow access at this location.

View of damage to slope from vehicle traffic. (Fall 2018)

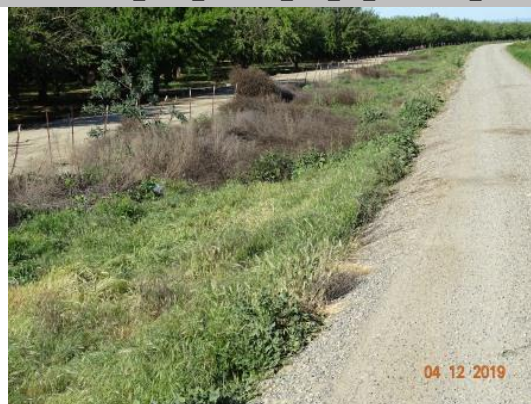
Photo 1 of 1 : SP_2019_NA0010_140_49_20190429_00048.jpg

LM Start	3.76	Rating **	U	Issue No.	49
LM End	5.38	Issue Type +	Ma	Location *	LS
Category	Earthen Levee			GPS Latitude/Longitude	
				Start	End
Item	Vegetation			36.767767 °	36.782291 °
				-120.233436 °	-120.223202 °
DWR ID	DWR_NA0010_24_s_2019_49				
Comment Code					
V1 : Control annual grass and weeds on the levee slopes and easements.					
Inspector Comment

View of landside slope looking downstream. (Spring 2019)

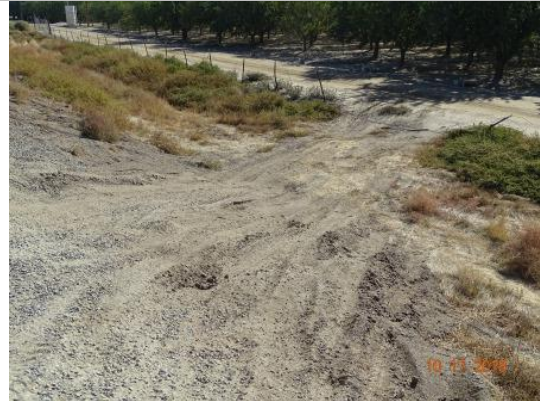
Photo 1 of 1 : SP_2019_NA0010_140_36_20190307_00016.jpg

LM Start	3.77	Rating **	M	Issue No.	36
LM End	3.77	Issue Type +	Ma	Location *	LS
Category	Earthen Levee			GPS Latitude/Longitude	
				Start	End
Item	Slope Stability			36.767784 °	36.767784 °
				-120.233252 °	-120.233252 °
DWR ID	DWR_NA0010_24_f_2018_36				
Comment Code					
S3 : Repair the levee slope damaged by vehicle traffic and prevent access where possible.					
Inspector Comment					
There is damage to the levee slope from vehicle traffic. The landowner appears to have removed a section of fencing to allow access at this location.

View of damage to slope from vehicle traffic. (Fall 2018)

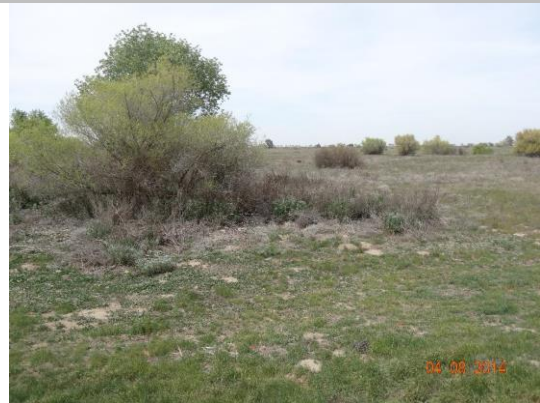
Photo 1 of 3 : UCIP_SP_2019_36849_67237.jpg

Comment Code					
Inspector Comment					
FS_ID:36849 DS_ID:19964 EP_NO: N/A Repair Type: Non-Urgent Crossing Status: Found UCIP Comments: 04/08/2014 Unable to confirm crossing alignment and appurtenances associated with this crossing. Multiple stand pipes visible on landward side. Need to contact owner to determine status of crossing and alignment. (DWR UCIP - O. Magana) FIELD_STRUCT_DESC: 30-inch by 30-inch square reinforced concrete box drainage discharge culvert through the levee, 12.5 feet below the crown. Pump on the landside (LS). Concrete riser with slide gate on the waterside (WS) slope. Screw gate on the LS shoulder. (Plans to construct a new discharge structure and to rehabilitate one existing diversion structure to return intercepted seepage to the San Joaquin River authorized under Permit No. 13085, 1981 - Diener, Dry River Farms). [Additional Reference(s): DWR Levee Log, 2002]. FS Date: 4/8/2014

View of waterwar side.

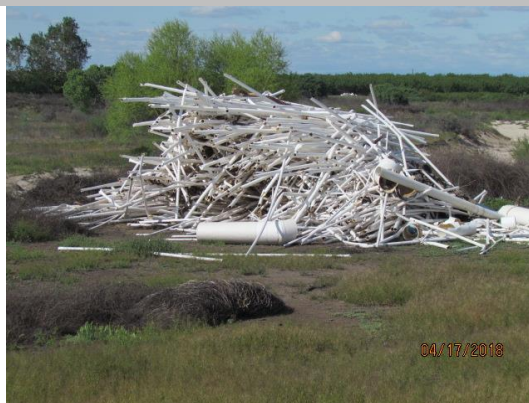
Photo 1 of 1 : SP_2019_NA0010_140_25_20190307_00009.jpg

LM Start	6.30	Rating **	U	Issue No.	25
LM End	6.30	Issue Type +	En	Location *	WS
Category	Earthen Levee			GPS Latitude/Longitude	
				Start	End
Item	Encroachments			36.788095 °	36.788095 °
				-120.210264 °	-120.210264 °
DWR ID	DWR_NA0010_24_s_2018_25				
Comment Code					
MA : Material					
Inspector Comment					
There is a stockpile of PVC pipe on the waterward berm.

Looking east at PVC pipes on waterward berm. (Spring 2018)

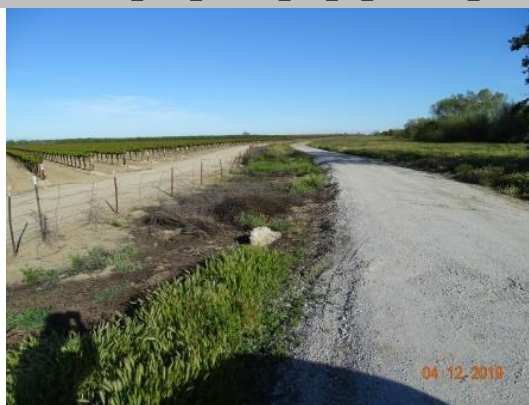
Photo 1 of 1 : SP_2019_NA0010_140_33_20190429_00051.jpg

LM Start	6.72	Rating **	U	Issue No.	33
LM End	7.33	Issue Type +	Ma	Location *	LS
Category	Earthen Levee			GPS Latitude/Longitude	
				Start	End
Item	Vegetation			36.786687 °	36.779339 °
				-120.204749 °	-120.199032 °
DWR ID	DWR_NA0010_24_s_2019_33				
Comment Code					
V1 : Control annual grass and weeds on the levee slopes and easements.					
Inspector Comment

View of landside slope looking upstream. (Spring 2019)

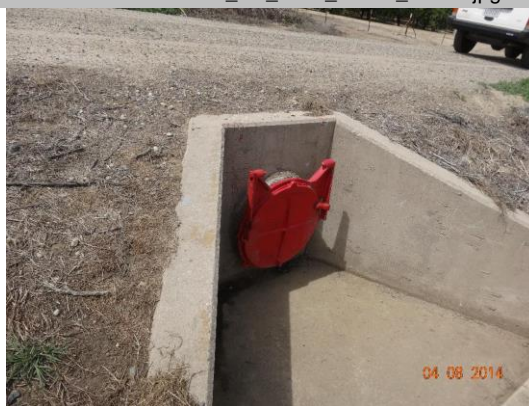
Photo 3 of 3 : UCIP_SP_2019_50056_60106.jpg

Comment Code						
Inspector Comment						
FS_ID:50056 DS_ID:19957 EP_NO: N/A Repair Type: Non-Urgent Crossing Status: Found UCIP Comments: 7/20/2016 same as previous inspection. Crossing has been downgraded from Urgent to Non-Urgent PVC does not prevent WS flap gate from closing. (DWR UCIP - omagana)4/08/2014 Unauthorized PVC pipe through existinig crossing. PVC distorted inside--Need to contact owner to correct issue. If crossing was allowed need to contact owner for permit number issue for crossing variance. (DWR UCIP - omagana) FIELD_STRUCT_DESC: 24-inch corrugated metal gravity drainage pipe through the levee, 3.6 feet below the crown. Flap gate on the waterside (WS) end. Concrete headwall on the landside (LS) end. Concrete U-shaped headwall on the WS end. [Additional Reference(s): DWR Levee Log, 2002]. FS Date: 7/20/2016

Flap gate visible on WS.

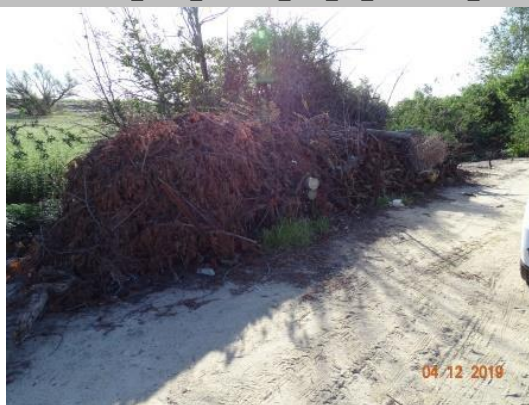
Photo 1 of 1 : SP_2019_NA0010_140_19_20190429_00052.jpg

LM Start	7.38	Rating **	U	Issue No.	19
LM End	7.38	Issue Type +	En	Location *	WS
Category	Earthen Levee			GPS Latitude/Longitude	
				Start	End
Item	Encroachments			36.778838 °	36.778838 °
				-120.198478 °	-120.198478 °
DWR ID	DWR_NA0010_24_s_2019_19				
Comment Code					
TR : Tree or limb					
Inspector Comment

View of tree punings left on waterside shoulder. (Spring 2019)

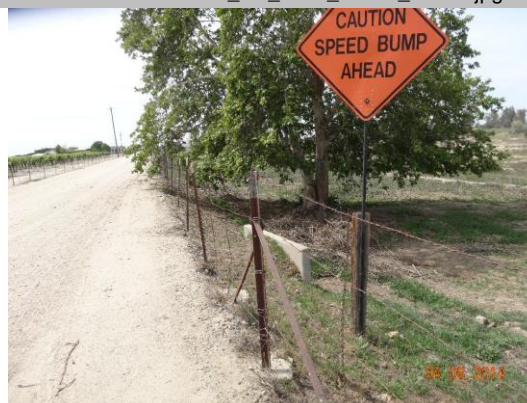
Photo 1 of 2 : UCIP_SP_2019_33272_60121.jpg

LM Start	8.33	Rating **	M	Issue No.	273
LM End	8.33	Issue Type +	Ma	Location *	
Category	Supplemental			GPS Latitude/Longitude	
				Start	End
Item	DWR UCIP LMA Responsibility			36.778084 °	36.778084 °
				-120.184454 °	-120.184454 °
DWR ID	19960				
Comment Code					
Inspector Comment					
FS_ID:33272					
DS_ID:19960					
EP_NO: N/A					
Repair Type: Non-Urgent					
Crossing Status: Found					
UCIP Comments: 04/08/2014 Barbed wire along levee shoulder--no access. Need to confirm crossing size and condition of crossing. (DWR UCIP - O. Magana)					
FIELD_STRUCT_DESC: 12-inch reinforced concrete gravity drainage pipe through the levee, 3 feet below the crown. Flap gate on the waterside (WS) end. Concrete headwall on the WS end. [Additional Reference(s): DWR Levee Log, 2002. USACE San Joaquin O&M Manual 601.1, 1967, (HLM 8.32)].					
FS Date: 4/8/2014

View of waterward side.

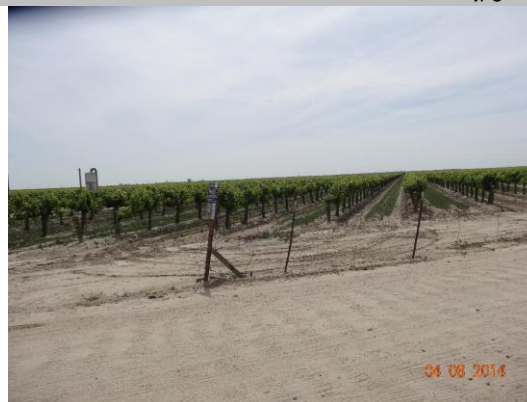
Photo 2 of 2 : UCIP_SP_2019_33272_60120.jpg

View of landward side.

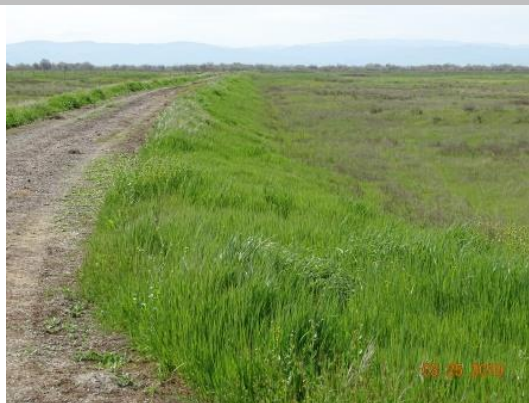
Photo 1 of 2 : SP_2019_NA0010_141_7_20190419_00032.jpg

LM Start	0.00	Rating **	U	Issue No.	7
LM End	2.48	Issue Type +	Ma	Location *	LS
Category	Earthen Levee			GPS Latitude/Longitude	
				Start	End
Item	Vegetation			37.296261 °	37.271165 °
				-120.880678 °	-120.866615 °
DWR ID	DWR_NA0010_25_f_2015_7				
Comment Code					
V2 : Remove the wild growth other than native grasses from the levee slopes.					
Inspector Comment

View of landside slope looking west. (Spring 2019)

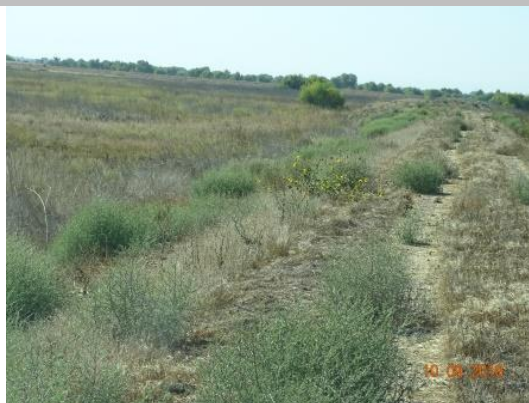
Photo 2 of 2 : SP_2019_NA0010_141_7_20190307_00001.jpg

View of landside slope looking south. (Fall 2018)

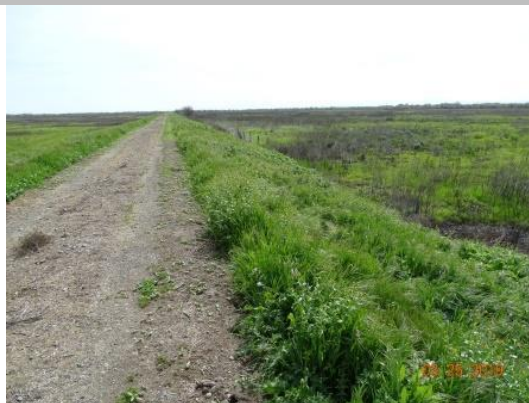
Photo 1 of 1 : SP_2019_NA0010_141_9_20190419_00033.jpg

LM Start	0.00	Rating **	U	Issue No.	9
LM End	2.48	Issue Type +	Ma	Location *	WS
Category	Earthen Levee			GPS Latitude/Longitude	
				Start	End
Item	Vegetation			37.296261 °	37.271161 °
				-120.880678 °	-120.866612 °
DWR ID	DWR_NA0010_25_f_2015_9				
Comment Code					
V2 : Remove the wild growth other than native grasses from the levee slopes.					
Inspector Comment

View of waterside slope looking south. (Spring 2019)

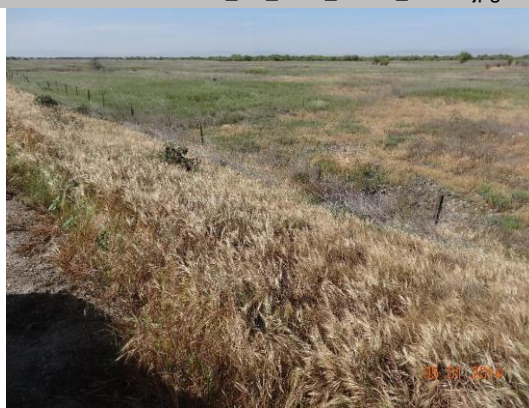
Photo 1 of 3 : UCIP_SP_2019_39501_67242.jpg

Comment Code						
Inspector Comment						
FS_ID:39501 DS_ID:19965 EP_NO: N/A Repair Type: Non-Urgent Crossing Status: Found UCIP Comments: 05/01/2014 Dense vegetation limits the inspectors visibility to identify signs of pipe failure (leaks) along the slope. Recommend removing vegetation along pipe alignment to conduct proper inspection of structure. Sediment buildup in pipe visible from landward side--recommend clearing. (DWR UCIP - O. Magana) FIELD_STRUCT_DESC: 24-inch corrugated metal gravity drainage pipe through the levee, 10 feet below the crown. Flap gate on the waterside (WS) end. [Additional Reference(s): DWR Levee Log, 2002. USACE San Joaquin O&M Manual 601.1, 1967, (HLM 0.02)]. FS Date: 5/1/2014

View of waterward side--dense vegetation on waterward side.

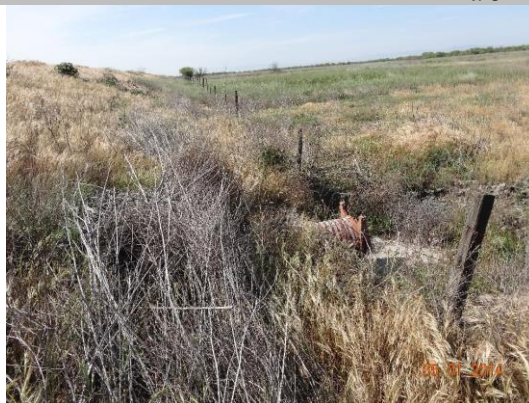
Photo 2 of 3 : UCIP_SP_2019_39501_67240.jpg

Comment Code						
Inspector Comment						
FS_ID:39501 DS_ID:19965 EP_NO: N/A Repair Type: Non-Urgent Crossing Status: Found UCIP Comments: 05/01/2014 Dense vegetation limits the inspectors visibility to identify signs of pipe failure (leaks) along the slope. Recommend removing vegetation along pipe alignment to conduct proper inspection of structure. Sediment buildup in pipe visible from landward side--recommend clearing. (DWR UCIP - O. Magana) FIELD_STRUCT_DESC: 24-inch corrugated metal gravity drainage pipe through the levee, 10 feet below the crown. Flap gate on the waterside (WS) end. [Additional Reference(s): DWR Levee Log, 2002. USACE San Joaquin O&M Manual 601.1, 1967, (HLM 0.02)]. FS Date: 5/1/2014

Pipe daylight visible on waterward toe.

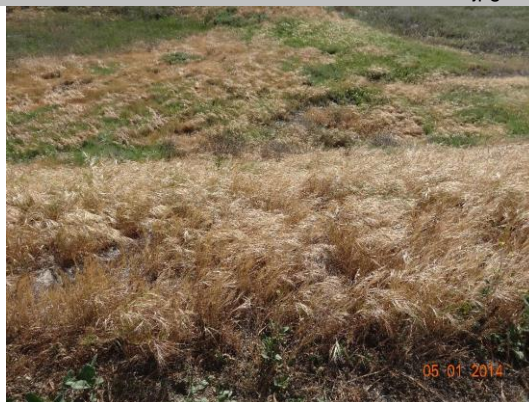
Photo 3 of 3 : UCIP_SP_2019_39501_67241.jpg

View of landward side--dense vegetation on landward side.

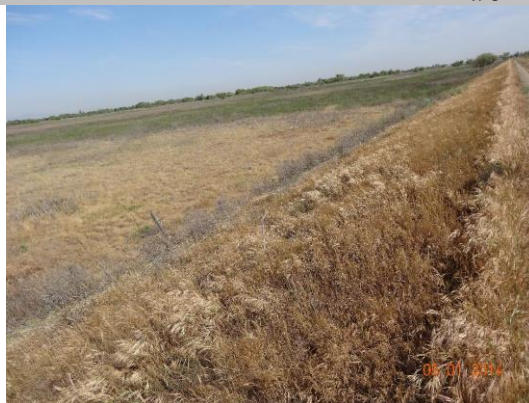
Photo 1 of 3 : UCIP_SP_2019_36851_67249.jpg

LM Start	0.36	Rating **	M	Issue No.	15
LM End	0.36	Issue Type +	Ma	Location *	
Category	Supplemental			GPS Latitude/Longitude	
				Start	End
Item	DWR UCIP LMA Responsibility			37.291173 °	37.291173 °
				-120.880731 °	-120.880731 °
DWR ID	19966				
Comment Code					
Inspector Comment					
FS_ID:36851 DS_ID:19966 EP_NO: N/A Repair Type: Non-Urgent Crossing Status: Found UCIP Comments: 05/01/2014 Dense vegetation limits the inspectors visibility to identify signs of pipe failure (leaks) along the slope. Recommend removing vegetation along pipe alignment to conduct proper inspection of structure. (DWR UCIP - O. Magana) FIELD_STRUCT_DESC: 24-inch corrugated metal gravity drainage pipe through the levee, 11.6 feet below the crown. Flap gate on the waterside (WS) end. [Additional Reference(s): DWR Levee Log, 2002. USACE San Joaquin O&M Manual 601.1, 1967, (HLM 0.35)]. FS Date: 5/1/2014

View of waterward side.

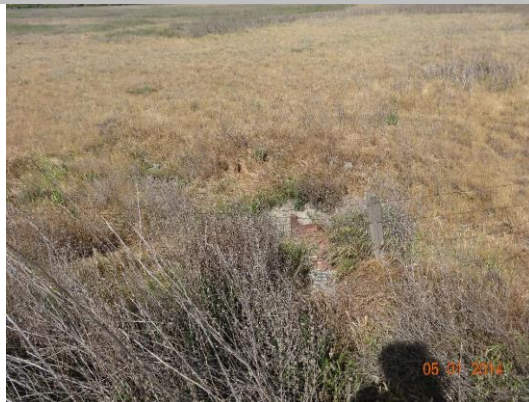
Photo 2 of 3 : UCIP_SP_2019_36851_67248.jpg

Pipe outlet visible on waterward side.

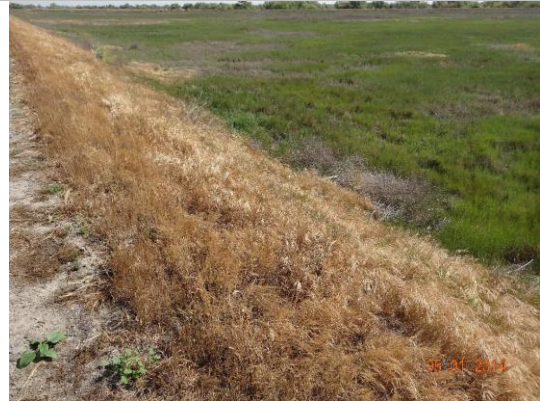
Photo 3 of 3 : UCIP_SP_2019_36851_67247.jpg

Comment Code					
Inspector Comment					
FS_ID:36851 DS_ID:19966 EP_NO: N/A Repair Type: Non-Urgent Crossing Status: Found UCIP Comments: 05/01/2014 Dense vegetation limits the inspectors visibility to identify signs of pipe failure (leaks) along the slope. Recommend removing vegetation along pipe alignment to conduct proper inspection of structure. (DWR UCIP - O. Magana) FIELD_STRUCT_DESC: 24-inch corrugated metal gravity drainage pipe through the levee, 11.6 feet below the crown. Flap gate on the waterside (WS) end. [Additional Reference(s): DWR Levee Log, 2002. USACE San Joaquin O&M Manual 601.1, 1967, (HLM 0.35)]. FS Date: 5/1/2014

View of landward side.

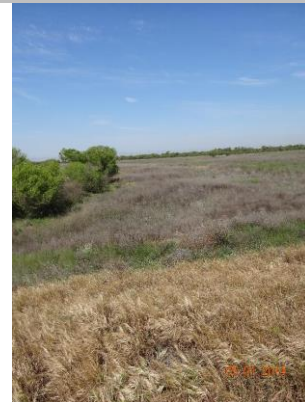
Photo 1 of 3 : UCIP_SP_2019_36852_67250.jpg

LM Start	0.59	Rating **	M	Issue No.	16
LM End	0.59	Issue Type +	Ma	Location *	
Category	Supplemental			GPS Latitude/Longitude	
				Start	End
Item	DWR UCIP LMA Responsibility			37.287744 °	37.287744 °
				-120.880645 °	-120.880645 °
DWR ID	19967				
Comment Code					
Inspector Comment					
FS_ID:36852 DS_ID:19967 EP_NO: N/A Repair Type: Non-Urgent Crossing Status: Found UCIP Comments: 05/01/2014 Dense vegetation limits the inspectors visibility to identify signs of pipe failure (leaks) along the slope. Recommend removing vegetation along pipe alignment to conduct proper inspection of structure. (DWR UCIP - O. Magana) FIELD_STRUCT_DESC: 24-inch corrugated metal gravity drainage pipe through the levee, 14.7 feet below the crown. Flap gate on the waterside (WS) end. [Additional Reference(s): DWR Levee Log, 2002. USACE San Joaquin O&M Manual 601.1, 1967, (HLM 0.59)]. FS Date: 5/1/2014

Overview of waterward side--Salt Slough.

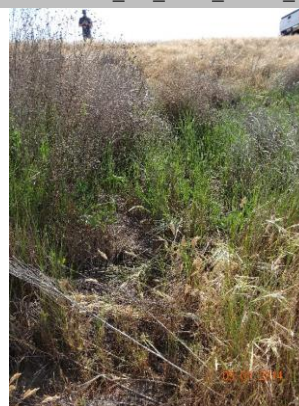
Photo 2 of 3 : UCIP_SP_2019_36852_67251.jpg

Comment Code						
Inspector Comment						
FS_ID:36852 DS_ID:19967 EP_NO: N/A Repair Type: Non-Urgent Crossing Status: Found UCIP Comments: 05/01/2014 Dense vegetation limits the inspectors visibility to identify signs of pipe failure (leaks) along the slope. Recommend removing vegetation along pipe alignment to conduct proper inspection of structure. (DWR UCIP - O. Magana) FIELD_STRUCT_DESC: 24-inch corrugated metal gravity drainage pipe through the levee, 14.7 feet below the crown. Flap gate on the waterside (WS) end. [Additional Reference(s): DWR Levee Log, 2002. USACE San Joaquin O&M Manual 601.1, 1967, (HLM 0.59)]. FS Date: 5/1/2014

View of waterward slope covered by dense vegetation.

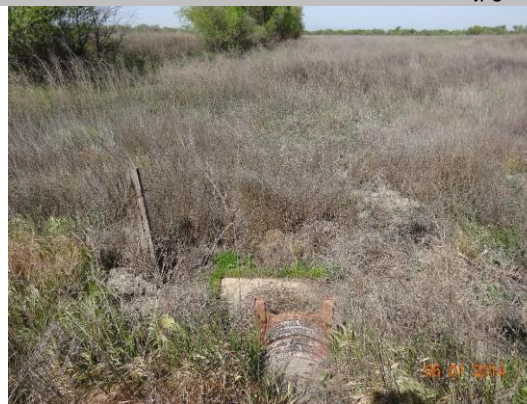
Photo 3 of 3 : UCIP_SP_2019_36852_67252.jpg

Pipe and flap gate visible on waterward side.

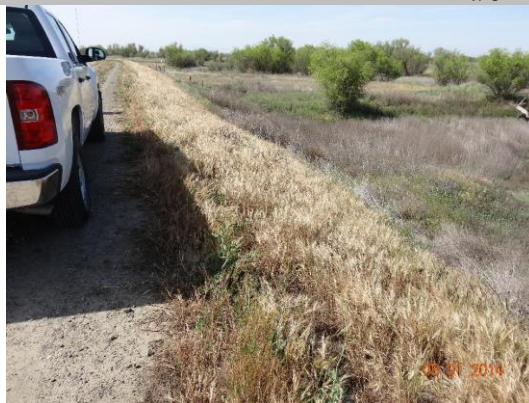
Photo 1 of 3 : UCIP_SP_2019_36853_67255.jpg

View of waterward side.

Comment Code						
Inspector Comment						
FS_ID:36853 DS_ID:19968 EP_NO: N/A Repair Type: Non-Urgent Crossing Status: Found UCIP Comments: 05/01/2014 Dense vegetation limits the inspectors visibility to identify signs of pipe failure (leaks) along the slope. Recommend removing vegetation along pipe alignment to conduct proper inspection of structure. (DWR UCIP - O. Magana) FIELD_STRUCT_DESC: 24-inch corrugated metal gravity drainage pipe through the levee, 11.4 feet below the crown. Flap gate on the waterside (WS) end. [Additional Reference(s): DWR Levee Log, 2002. USACE San Joaquin O&M Manual 601.1, 1967, (HLM 0.97)]. FS Date: 5/1/2014

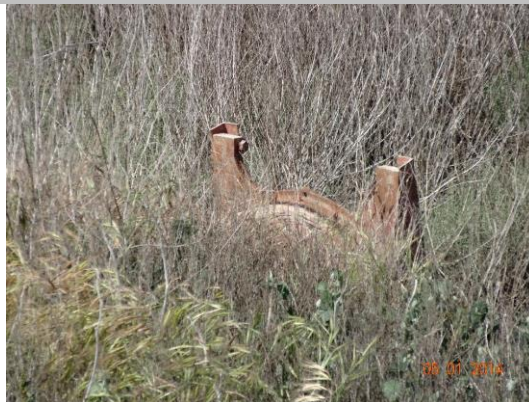
Photo 2 of 3 : UCIP_SP_2019_36853_67255.jpg

Pipe and evidence of flap gate visible on waterward side.

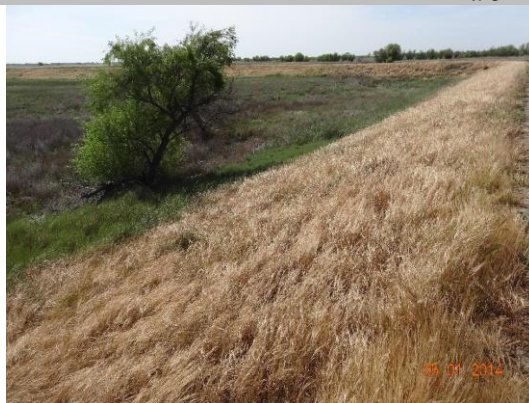
Photo 3 of 3 : UCIP_SP_2019_36853_67254.jpg

View of landward side.

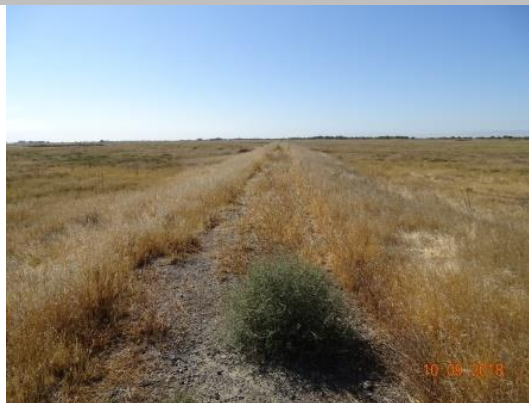
Photo 1 of 2 : SP_2019_NA0010_141_12_20190307_00010.jpg

LM Start	1.75	Rating **	M	Issue No.	12
LM End	2.49	Issue Type +	Ma	Location *	CR
Category	Earthen Levee			GPS Latitude/Longitude	
				Start	End
Item	Vegetation			37.281677 °	37.271073 °
				-120.867254 °	-120.866562 °
DWR ID	DWR_NA0010_25_f_2018_12				
Comment Code					
V9 : Keep the crown roadway free of vegetation.					
Inspector Comment					
There is heavy vegetation along the crown.

Looking east at typical view of levee crown. (Fall 2018)

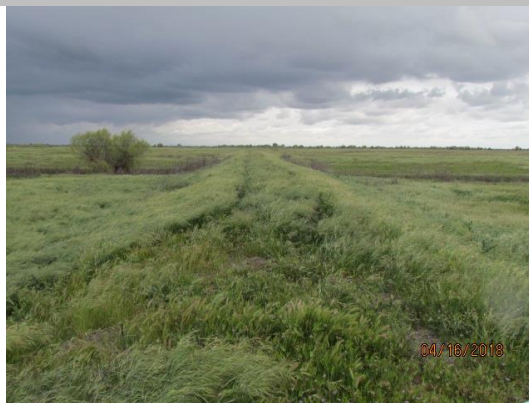
Photo 2 of 2 : SP_2019_NA0010_141_12_20190307_00011.jpg

Looking east at typical view of levee crown. (Spring 2018)

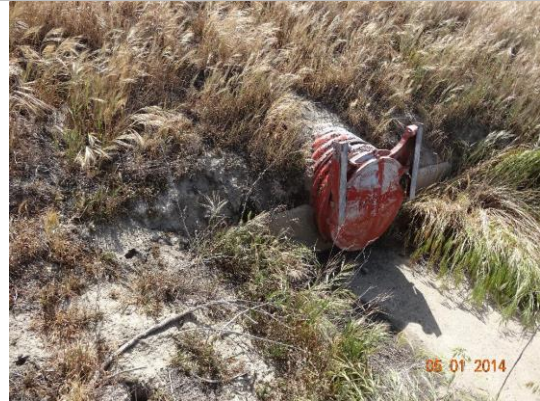
Photo 3 of 3 : UCIP_SP_2019_36854_67261.jpg

Comment Code					
Inspector Comment					
FS_ID:36854					
DS_ID:19969					
EP_NO: N/A					
Repair Type: Non-Urgent					
Crossing Status: Found					
UCIP Comments: 05/01/2014 Dense vegetation limits the inspectors visibility to identify signs of pipe failure (leaks) along the slope.					
Recommend removing vegetation along pipe alignment to conduct proper inspection of structure. (DWR UCIP - O. Magana)					
FIELD_STRUCT_DESC: 24-inch corrugated metal gravity drainage pipe through the levee, 4 feet below the crown. Flap gate on the waterside (WS) end. [Additional Reference(s): DWR Levee Log, 2002. USACE San Joaquin O&M Manual 601.1, 1967, (HLM 2.05)].					
FS Date: 5/1/2014

Flap gate and concrete headwall located on waterward toe.

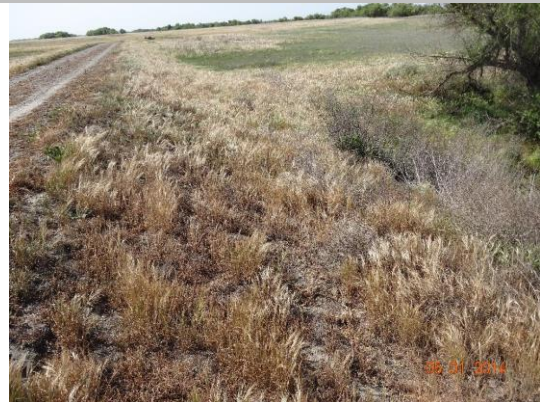
Photo 1 of 3 : UCIP_SP_2019_39502_67270.jpg

Comment Code					
Inspector Comment					
FS_ID:39502 DS_ID:19970 EP_NO: N/A Repair Type: Non-Urgent Crossing Status: Found UCIP Comments: 05/01/2014 Dense vegetation limits the inspectors visibility to identify signs of pipe failure (leaks) along the slope. Recommend removing vegetation along pipe alignment to conduct proper inspection of structure. Sediment buildup in pipe visible on landward side--recommend clearing. (DWR UCIP - O. Magana) FIELD_STRUCT_DESC: 24-inch corrugated metal gravity drainage pipe through the levee, 11.2 feet below the crown. Flap gate on the waterside (WS) end. [Additional Reference(s): DWR Levee Log, 2002. USACE San Joaquin O&M Manual 601.1, 1967, (HLM 2.45)]. FS Date: 5/1/2014 4:04:00 PM

View of waterward side.
