# Flood Control Project Maintenance Levee Inspections LMA District Cover Sheet

## Lower San Joaquin Levee District

**Flood Control Project Maintenance  
Levee Inspections  
Unit Cover Sheet**

Waterway			Bank	Unit Miles
Unit No. 01 San Joaquin River			Right	22.52
	Spring (March - May)	Summer (June - August)	(September - November) Fall	Winter (December - February)
Unit Maintenance Rating (Fall Only)				
Date of Inspection	5/4/2021 - 5/4/2021			
DWR Inspector	Corey Fujitani			
Accompanied By

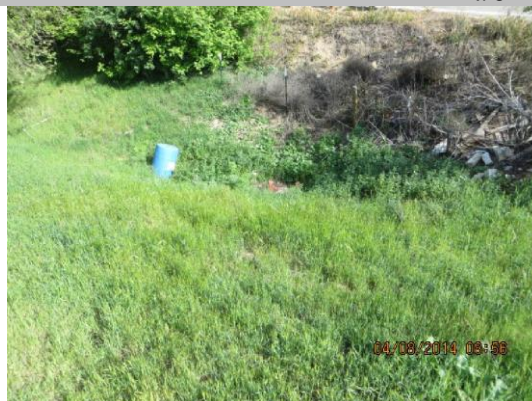
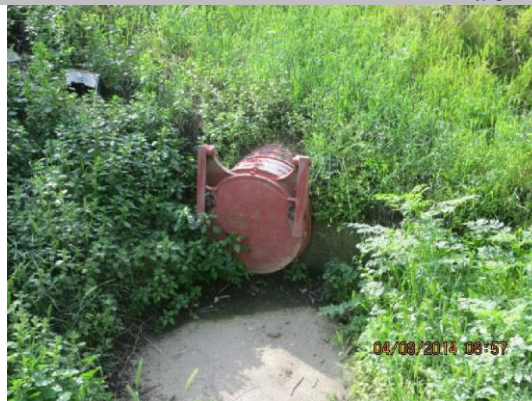
FS\_ID:62752  
DS\_ID:19650  
EP\_NO: N/A  
Repair Type: Urgent  
Crossing Status: Found  
UCIP Comments: 10/06/2020 Pipe status is still Urgent. DWR DMP has found integrity issues, LOF between 4 and 5. Crossing will be monitored until funding becomes available for rehabilitation. Dense vegetation was found along the LS and WS. No permit was found for this crossing. No permit was found authorizing this encroachment. CVFPB will need to review crossing to determine owner. (B. Singh - GEI, O. Magana - DWR UCIP)04/08/2014 Dense vegetation limits the inspector's visibility to identify signs of pipe failure (leaks) along the waterward slope and landward toe. Recommend removing vegetation along pipe alignment and landward toe to conduct proper inspection of structure and appurtenances. (W. Wylie - DWR UCIP)  
FIELD\_STRUCT\_DESC: 24-inch corrugated metal gravity drainage pipe through the levee, 10.5 feet below the crown. Flap gate on the waterside (WS) end. Brass cap No. 108 bench mark (BM) on the headwall on the landside (LS), elevation 65.1 feet, USGS Datum.

Flapgate on WS toe.

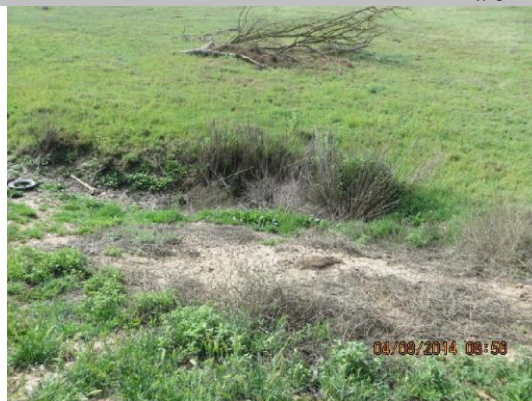
Photo 3 of 3 : UCIP\_SP\_2021\_62752\_60602.jpg

Headwall on LS toe.

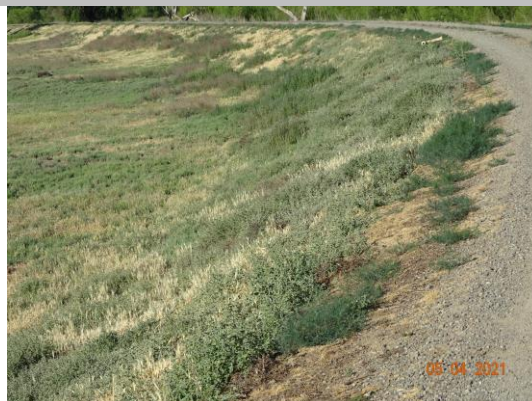
Photo 1 of 1 : SP\_2021\_NA0010\_118\_96\_20210517\_00301.jpg

LM Start	0.01	Rating **	M	Issue No.	96
LM End	0.14	Issue Type +	Ma	Location *	LS
Category	Earthen Levee			GPS Latitude/Longitude	
				Start	End
Item	Vegetation			37.348629 °	37.347253 °
				-120.958901 °	-120.960480 °
DWR ID	DWR_NA0010_01_s_2021_96				
Comment Code					
V1 : Control annual grass and weeds on the levee slopes and easements.					
Inspector Comment

View of the landside slope looking upstream. (Spring 2021)

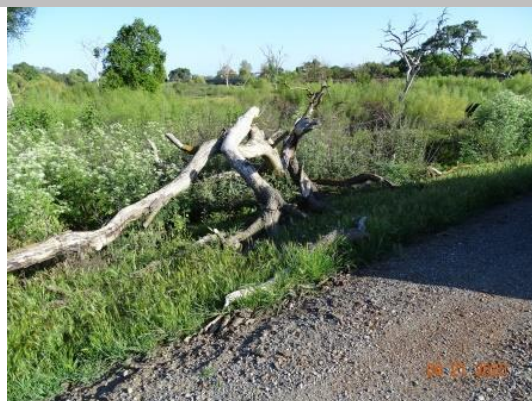
Photo 1 of 1 : SP\_2021\_NA0010\_118\_143\_20210308\_00029.jpg

LM Start	0.12	Rating **	M	Issue No.	143
LM End	0.12	Issue Type +	Ma	Location *	WS
Category	Earthen Levee			GPS Latitude/Longitude	
				Start	End
Item	Encroachments			37.347444 °	37.347444 °
				-120.960311 °	-120.960311 °
DWR ID	DWR_NA0010_01_s_2020_143				
Comment Code					
TR : Tree or limb					
Inspector Comment

Downed tree limb should be removed from the waterside shoulder. (Spring 2020)

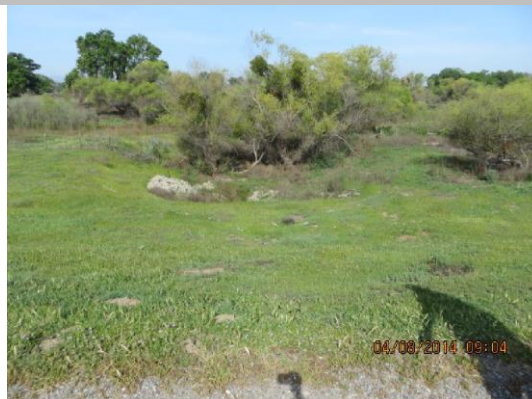
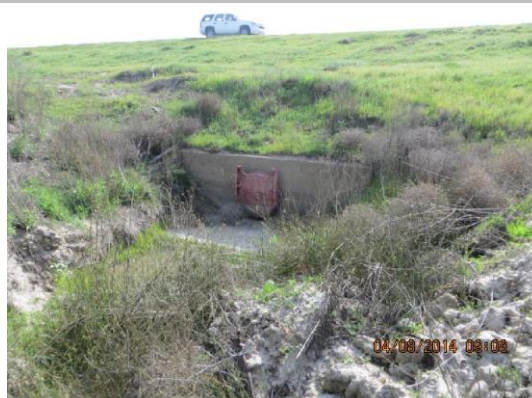
Comment Code					
Inspector Comment					
FS_ID:62609 DS_ID:19651 EP_NO: N/A Repair Type: Non-Urgent Crossing Status: Found UCIP Comments: 10/06/2020 Pipe status is still Non-Urgent. No permit was found authorizing this encroachment. Recommend maintenance to clear up sediment buildup through the pipe. CVFPB will need to review crossing to determine owner. DWR DMP has not completed an internal inspection of the pipe, but is scheduled for 2021. (B. Singh - GEI, O. Magana - DWR UCIP)04/08/2014 Pipe has significant sediment buildup and shows some signs of corrosion at landward toe. Recommend cleaning sediment from inside pipe and check wall integrity. (W. Wylie - DWR UCIP) FIELD_STRUCT_DESC: 36-inch corrugated metal gravity drainage pipe through the levee, 18.5 feet below the crown. Flap gate on the waterside (WS) end. Brass cap No. 108 bench mark (BM) on the headwall on the landside (LS). [Additional Reference(s): DWR Levee Log, 2002 (HLM 0.35), listed as 36-inch corrugated metal pipe (CMP). USACE San Joaquin O&M Manual, Unit 601 Part 1 (SJR601.1), 1967, Revised 25 May 2011, (HLM 0.35), listed as a 36-inch CMP]. FS Date: 10/6/2020

Flapgate and headwall visible off WS toe.

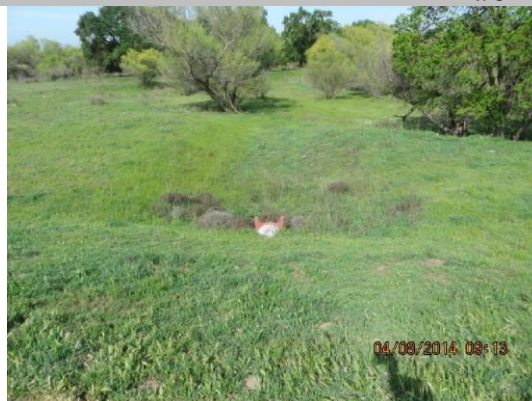
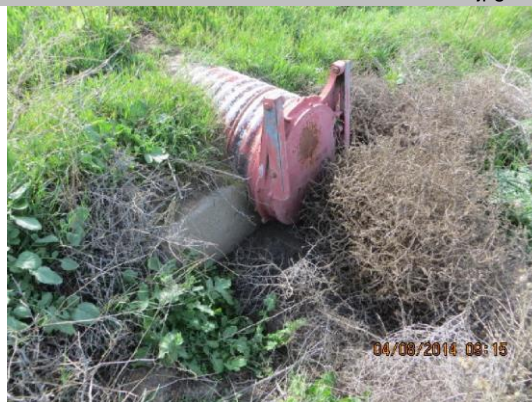
FS\_ID:62645  
DS\_ID:19583  
EP\_NO: N/A  
Repair Type: Non-Urgent  
Crossing Status: Found  
UCIP Comments: 10/06/2020 Pipe status is still Non-Urgent. No permit was found authorizing this encroachment. Rodent activity; recommend mitigation. CVFPB will need to review crossing to determine owner. DWR DMP has not found internal issues, LOF between 1 and 2. Recommend inspection in 5 years. (B. Singh - GEI, O. Magana - DWR UCIP)04/08/2014 Recommend removing vegetation pile from waterward toe. (W. Wylie - DWR UCIP)  
FIELD\_STRUCT\_DESC: 24-inch corrugated metal gravity drainage pipe through the levee, 8.5 feet below the crown. Flap gate on the waterside (WS) end. Brass cap No. 108 bench mark (BM) on the headwall on the landside (LS). [Additional Reference(s): DWR Levee Log, 2002 (HLM 0.62), listed as a 24-inch corrugated metal pipe (CMP). USACE San Joaquin O&M Manual, Unit 601 Part 1 (SJR601.1), 1967, Revised 25 May 2011, (HLM 0.62), listed as a 24-inch CMP].

Flapgate and headwall visible on WS toe.

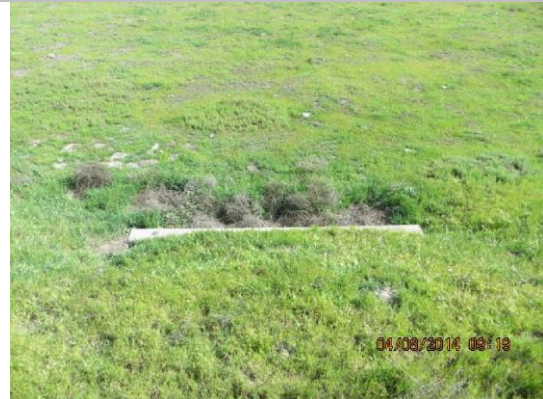
Photo 2 of 3 : UCIP\_SP\_2021\_62646\_60626.jpg

Pipe and headwall visible on LS toe.

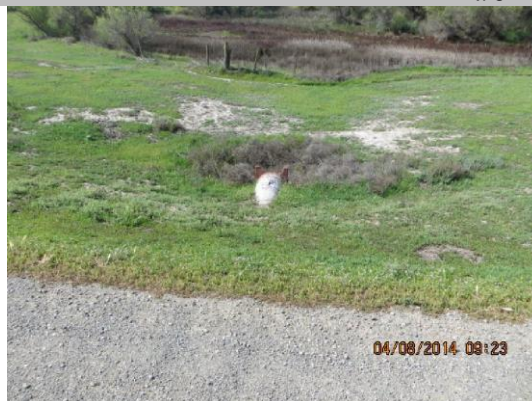
Photo 1 of 3 : UCIP\_SP\_2021\_62648\_60632.jpg

Comment Code						
Inspector Comment						
FS_ID:62648 DS_ID:19585 EP_NO: N/A Repair Type: Urgent Crossing Status: Found UCIP Comments: 10/06/2020 Pipe status is still Urgent. DWR DMP has found integrity issues, likelihood of failure between 5 and 6. Scour visible near LS toe surrounding headwall. Crossing will be monitored until funding becomes available for removal. No permit was found authorizing this encroachment. CVFPB will need to review crossing to determine owner. (B. Singh - GEI, O. Magana - DWR UCIP)04/08/2014 Moderate erosion around headwall on landward toe. May or may not be an issue. Need to contact owner to determine status of crossing and to address erosion issue on landward side. (W. Wylie - DWR UCIP) FIELD_STRUCT_DESC: 24-inch corrugated metal gravity drainage pipe through the levee, 9 feet below the crown. Flap gate on the waterside (WS) end. Brass cap No. 108 bench mark (BM) on the headwall on the landside (LS). [Additional Reference(s): DWR Levee Log, 2002 (HLM 0.96), listed as a 24-inch corrugated metal pipe (CMP). USACE San Joaquin O&M Manual, Unit 601 Part 1 (SJR601.1), 1967, Revised 25 May 2011, (HLM 0.95), listed as a 24-inch CMP]. FS Date: 10/6/2020

Flapgate, pipe, and headwall on WS toe.

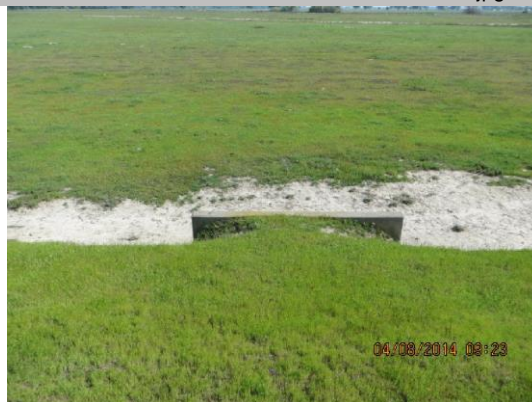
Photo 2 of 3 : UCIP\_SP\_2021\_62648\_60631.jpg

Concrete headwall and pipe visible at LS toe.

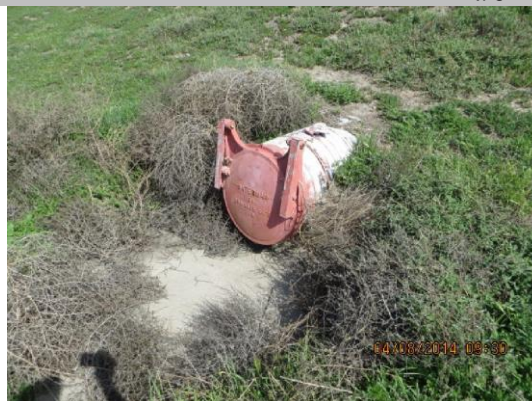
Photo 2 of 3 : UCIP\_SP\_2021\_62615\_60643.jpg

Pipe, headwall, and flapgate visible on WS toe.

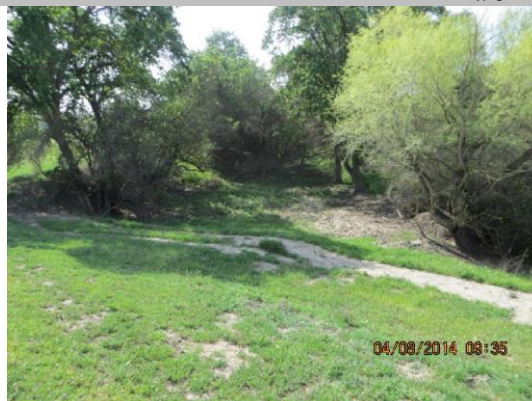
Photo 1 of 3 : UCIP\_SP\_2021\_62617\_60649.jpg

FS\_ID:62617  
DS\_ID:19587  
EP\_NO: N/A  
Repair Type: Non-Urgent  
Crossing Status: Found  
UCIP Comments: 10/06/2020 Pipe status is still Non-Urgent. No permit was found authorizing this encroachment. CVFPB will need to review crossing to determine owner. DWR DMP has not completed an internal inspection of the pipe but it is scheduled for 2021. (B. Singh - GEI, O. Magana - DWR UCIP)  
FIELD\_STRUCT\_DESC: 36-inch corrugated metal gravity drainage pipe through the levee, 12.8 feet below the crown. Flap gate on the waterside (WS) end. Brass cap No. 108 bench mark (BM) on the headwall on the landside (LS). Pipe crosses through the levee at about a 45 degree angle to the crown. [Additional Reference(s): DWR Levee Log, 2002 (HLM 1.35), listed as a 36-inch corrugated metal pipe. USACE San Joaquin O&M Manual, Unit 601 Part 1 (SJR601.1), 1967, Revised 25 May 2011, (HLM 1.34), listed as a 36-inch CMP].

Concrete headwall and flapgate visible at WS toe.

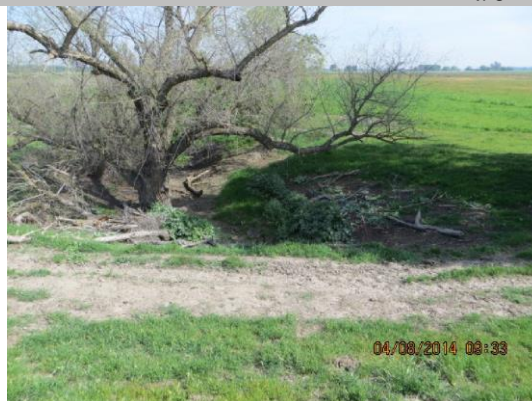
Photo 3 of 3 : UCIP\_SP\_2021\_62617\_60647.jpg

Concrete headwall and pipe visible at LS toe.

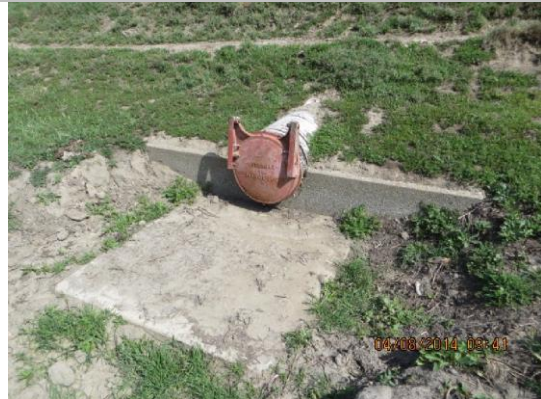
Photo 2 of 3 : UCIP\_SP\_2021\_62618\_60653.jpg

UCIP Comments: 10/06/2020 Pipe status is still Non-Urgent. No permit was found authorizing this encroachment. CVFPB will need to review crossing to determine owner. DWR DMP has not found internal issues, LOF between 1 and 2. Recommend inspection in 5 years. (B. Singh - GEI, O. Magana - DWR UCIP)04/08/2014 Some sediment buildup inside pipe at LS toe. Recommend contacting owner to clear sediment buildup and check wall integrity through pipe section. (W. Wylie - DWR UCIP)

Pipe, flapgat, and concrete headwall visible on WS toe.

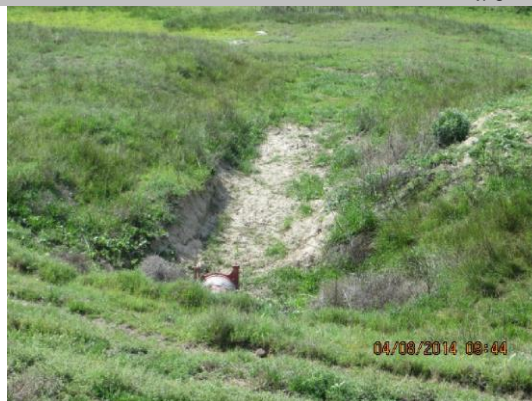
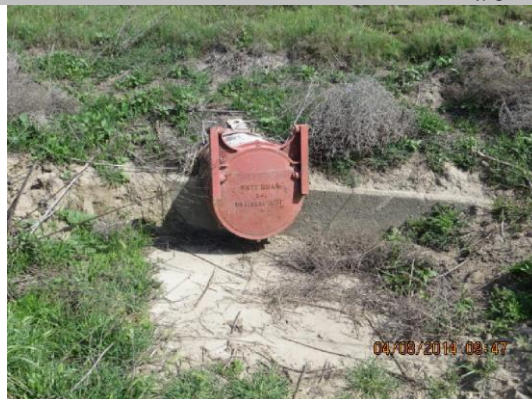
Comment Code						
Inspector Comment						
FS_ID:62649 DS_ID:19589 EP_NO: N/A Repair Type: Urgent Crossing Status: Found UCIP Comments: 10/06/2020 Pipe status is Urgent. DWR DMP has found integrity issues, LOF between 4 and 5. Crossing will be monitored until funding becomes available for rehabilitation. No permit was found authorizing this encroachment. CVFPB will need to review crossing to determine owner. Dense vegetation; recommend vegetation removal along pipe alignment (B. Singh - GEI, O. Magana - DWR UCIP)04/08/2014 Heavy sediment buildup in pipe at LS toe. (DWR UCIP - W. Wylie) FIELD_STRUCT_DESC: 24-inch corrugated metal gravity drainage pipe through the levee, 13.6 feet below the crown. Flap gate on the waterside (WS) end. Brass cap No. 108 bench mark (BM) on the headwall on the landside (LS). [Additional Reference(s): DWR Levee Log, 2002 (HLM 1.70), listed as a 24-inch corrugated metal pipe (CMP). USACE San Joaquin O&M Manual, Unit 601 Part 1 (SJR601.1), 1967, Revised 25 May 2011, (HLM 1.69), listed as a 24-inch CMP]. FS Date: 10/6/2020

Pipe, headwall, and flapgate visible on WS toe.

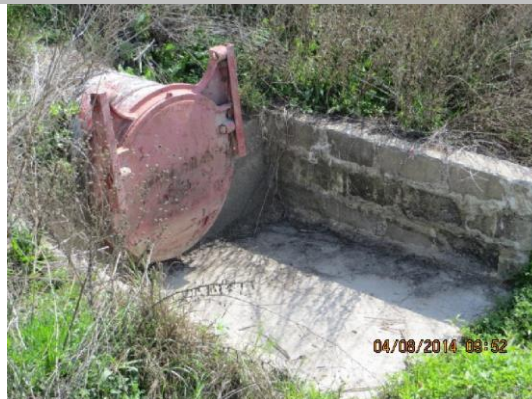
Photo 2 of 3 : UCIP\_SP\_2021\_62750\_60667.jpg

Pipe, flapgate, and headwall visible at WS toe.

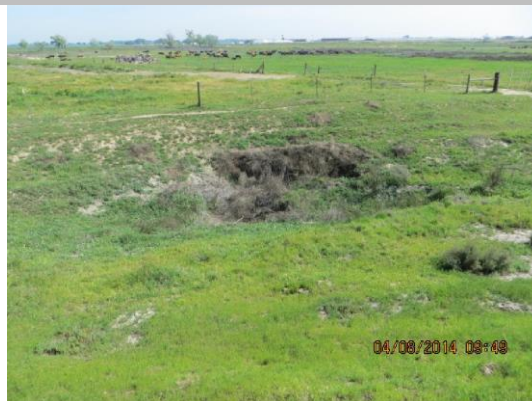
Photo 3 of 3 : UCIP\_SP\_2021\_62750\_60665.jpg

Pipe and concrete headwall visible at LS toe.

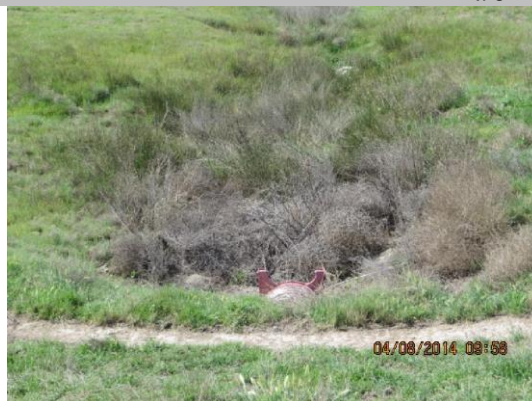
FS\_ID:62622  
DS\_ID:19591  
EP\_NO: N/A  
Repair Type: Non-Urgent  
Crossing Status: Found  
UCIP Comments: 10/06/2020 Pipe status is still Non-Urgent. No permit was found authorizing this encroachment. CVFPB will need to review crossing to determine owner. DWR DMP has not found internal issues, LOF between 1 and 2. Rodent activity, recommend mitigation. Recommend inspection in 5 years. (B. Singh - GEI, O. Magana - DWR UCIP)04/08/2014 Need to contact owner to determine crossing status. Inlet drop box silted in and needs to be cleaned out. (W. Wylie - DWR UCIP)  
FIELD\_STRUCT\_DESC: 24-inch corrugated metal gravity drainage pipe through the levee, 9.7 feet below the crown. Flap gate on the waterside (WS) end. Brass cap No. 100 bench mark (BM) on the headwall on the landside (LS). Wooden barrier around drop inlet on the LS toe. [Additional Reference(s): DWR Levee Log, 2002 (HLM 1.98), listed as a 24-inch corrugated metal pipe (CMP). USACE San Joaquin O&M Manual, Unit 601 Part 1 (SJR601.1), 1967, Revised 25 May 2011, (HLM 1.98), listed as a 24-inch CMP].

Concrete headwall and flapgate on WS toe.

Pipe, flapgate, and headwall on WS toe.

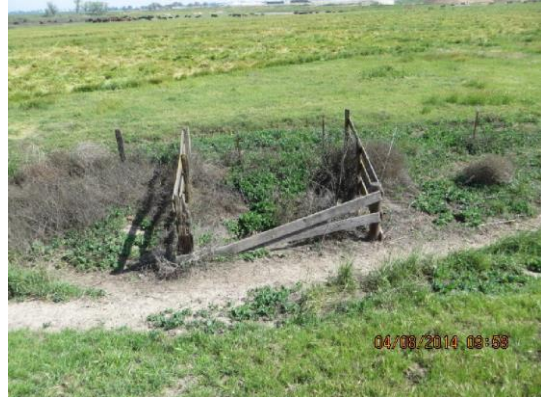
Photo 3 of 3 : UCIP\_SP\_2021\_62622\_60671.jpg

Wooded barrier around drop-inlet on LS toe.

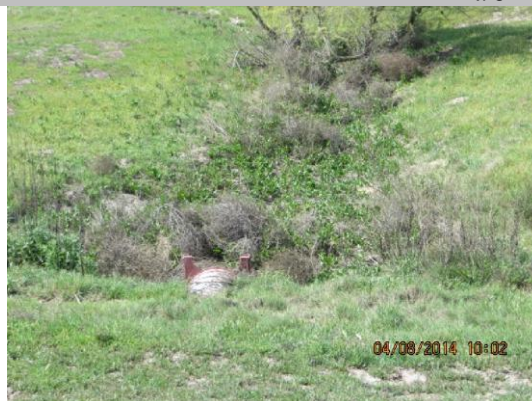
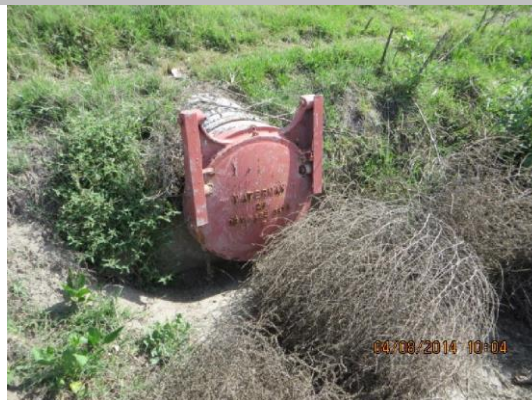
FS\_ID:62623  
DS\_ID:19570  
EP\_NO: N/A  
Repair Type: Non-Urgent  
Crossing Status: Found  
UCIP Comments: 10/06/2020 Pipe status is still Urgent. DWR DMP has found integrity issues, LOF between 4 and 5. Wooden barrier surrounding drop-inlet is dilapidated. Crossing will be monitored until funding becomes available for rehabilitation. No permit was found authorizing this encroachment. CVFPB will need to review crossing to determine owner. (B. Singh - GEI, O. Magana - DWR UCIP)04/08/2014 Unable to find inlet on landward toe. Recommend clearing vegetation on landward side to properly inspect inlet. (W. Wylie - DWR UCIP)  
FIELD\_STRUCT\_DESC: 24-inch corrugated metal gravity drainage pipe through the levee, 9.8 feet below the crown. Flap gate on the waterside (WS) end. Brass cap No. 100 bench mark (BM) on the headwall on the landside (LS). [Additional Reference(s): DWR Levee Log, 2002 (HLM 2.08), listed as a 24-inch corrugated metal pipe (CMP). USACE San Joaquin O&M Manual, Unit 601 Part 1 (SJR601.1), 1967, Revised 25 May 2011, (HLM 2.08), listed as a 24-inch CMP].

Pipe and flapgate visible on WS toe.

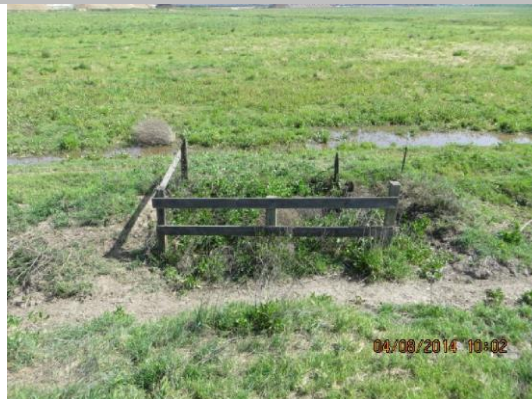
Photo 3 of 3 : UCIP\_SP\_2021\_62623\_60674.jpg

Wooded barrier around drop-inlet on LS toe.

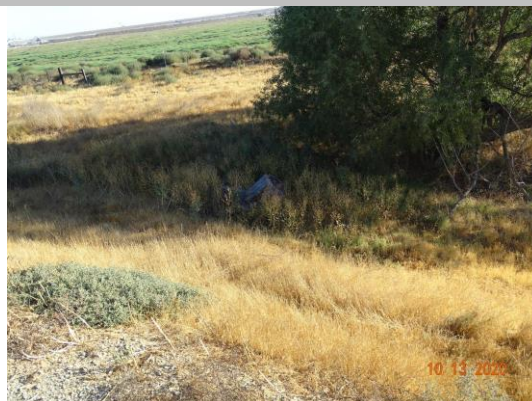
Photo 1 of 1 : SP\_2021\_NA0010\_118\_110\_20210308\_00018.jpg

LM Start	2.20	Rating **	N	Issue No.	110
LM End	2.20	Issue Type +	Ma	Location *	LS
Category	Earthen Levee			GPS Latitude/Longitude	
				Start	End
Item	Trim / Thin Trees			37.331820 °	37.331820 °
				-120.937605 °	-120.937605 °
DWR ID	DWR_NA0010_01_f _ 2018_110				
Comment Code					
T5 : Tree stumps.					
Inspector Comment					
Tree stump on landside slope should be removed.

View of tree stump on the landside slope. (Fall 2020)

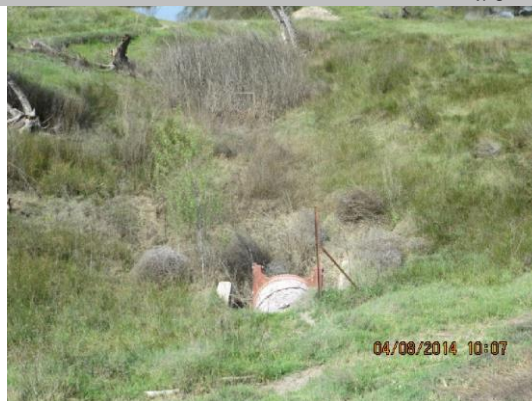
Photo 1 of 3 : UCIP\_SP\_2021\_62637\_71309.jpg

FS\_ID:62637  
DS\_ID:19571  
EP\_NO: N/A  
Repair Type: Non-Urgent  
Crossing Status: Found  
UCIP Comments: 10/06/2020 Pipe status is still Non-Urgent. Pipe angle through the levee. No permit was found authorizing this encroachment. CVFPB will need to review crossing to determine owner. DWR DMP has not completed an internal inspection of the pipe but is scheduled for 2021. (B. Singh - GEI, O. Magana - DWR UCIP)  
FIELD\_STRUCT\_DESC: 36-inch corrugated metal gravity drainage pipe through the levee, 12.6 feet below the crown. Flap gate on the waterside (WS) end. Brass cap No. 100 bench mark (BM) on the headwall on the landside (LS). Wooden barrier around drop inlet on the LS toe. [Additional Reference(s): DWR Levee Log, 2002 (HLM 2.25), listed as a 36-inch corrugated metal pipe (CMP). USACE San Joaquin O&M Manual, Unit 601 Part 1 (SJR601.1), 1967, Revised 25 May 2011, (HLM 2.25), listed as a 36-inch CMP].

Pipe and flapgate on WS toe.

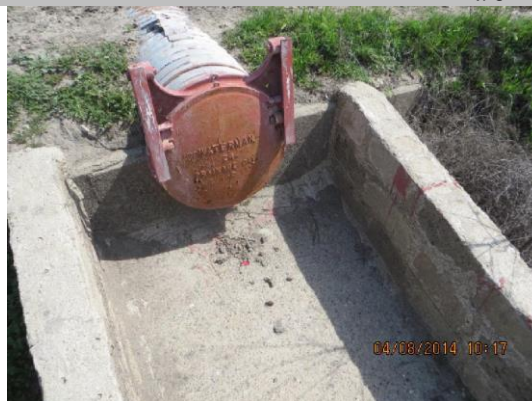
Photo 2 of 3 : UCIP\_SP\_2021\_62625\_60680.jpg

Pipe, headwall, and flapgate on WS toe.

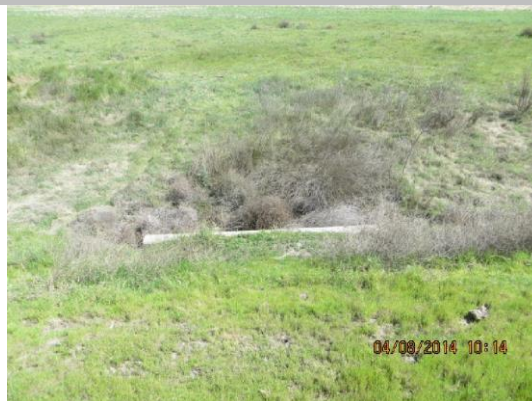
Photo 3 of 3 : UCIP\_SP\_2021\_62625\_60678.jpg

Pipe and headwall on LS toe.

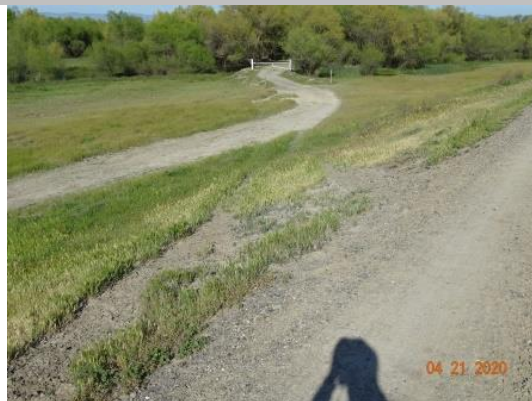
Photo 1 of 1 : SP\_2021\_NA0010\_118\_113\_20210308\_00020.jpg

LM Start	2.58	Rating **	A/W	Issue No.	113
LM End	2.58	Issue Type +	Ma	Location *	WS
Category	Earthen Levee			GPS Latitude/Longitude	
				Start	End
Item	Slope Stability			37.327936 °	37.327936 °
				-120.933013 °	-120.933013 °
DWR ID	DWR_NA0010_01_f_2018_113				
Comment Code					
S3 : Repair the levee slope damaged by vehicle traffic and prevent access where possible.					
Inspector Comment					
There is damage caused by vehicle traffic over the levee.

Slope damage by vehicle traffic. (Spring 2020)

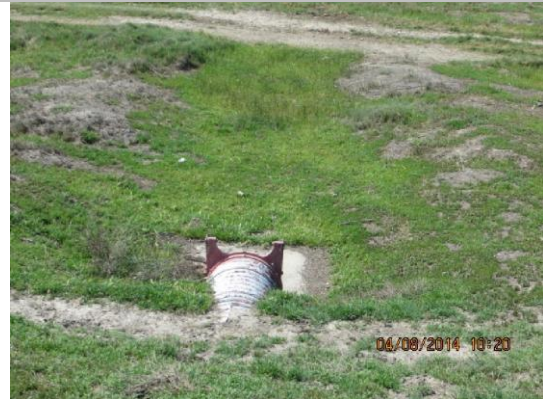
Photo 1 of 3 : UCIP\_SP\_2021\_62626\_60688.jpg

FS\_ID:62626  
DS\_ID:19573  
EP\_NO: N/A  
Repair Type: Non-Urgent  
Crossing Status: Found  
UCIP Comments: 10/06/2020 Pipe status is still Non-Urgent. No permit was found authorizing this encroachment. CVFPB will need to review crossing to determine owner. DWR DMP has not found internal issues, LOF between 1 and 2. Recommend inspection in 5 years. (B. Singh - GEI, O. Magana - DWR UCIP)04/08/2014 Sedimentation in pipe at landward toe. (W. Wylie - DWR UCIP)  
FIELD\_STRUCT\_DESC: 24-inch corrugated metal gravity drainage pipe through the levee, 7.3 feet below the crown. Flap gate on the waterside (WS) end. Brass cap No. 100 bench mark (BM) on the headwall on the landside (LS). [Additional Reference(s): DWR Levee Log, 2002 (HLM 2.71), listed as a 24-inch corrugated metal pipe (CMP). USACE San Joaquin O&M Manual, Unit 601 Part 1 (SJR601.1), 1967, Revised 25 May 2011, (HLM 2.70), listed as a 24-inch CMP].

Pipe, flapgate, and headwall on WS toe.

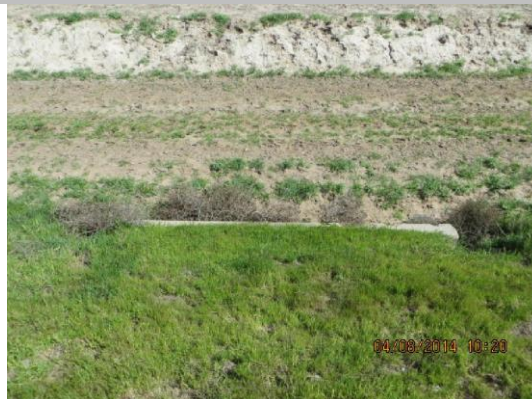
Photo 3 of 3 : UCIP\_SP\_2021\_62626\_60687.jpg

Pipe and headwall on LS toe.

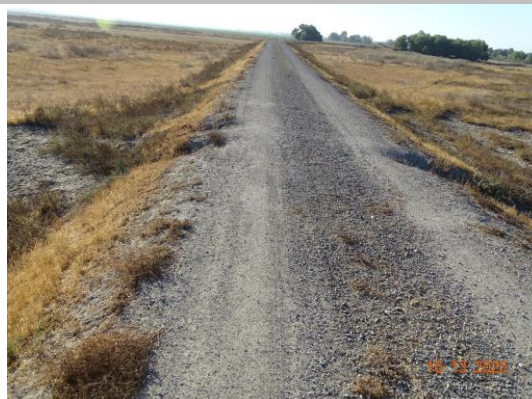
Photo 1 of 1 : SP\_2021\_NA0010\_118\_114\_20210308\_00021.jpg

LM Start	2.99	Rating **	U	Issue No.	114
LM End	2.99	Issue Type +	Ma	Location *	LS
Category	Earthen Levee			GPS Latitude/Longitude	
				Start	End
Item	Animal Control			37.323328 °	37.323328 °
				-120.929521 °	-120.929521 °
DWR ID	DWR_NA0010_01_f_2018_114				
Comment Code					
A2 : Repair the levee slope damaged by livestock and prevent large animal access.					
Inspector Comment					
Slope damage caused by livestock on both landside and waterside slope has eroded into the levee crown.

View of damage to both slope from livestock activity. (Fall 2020)

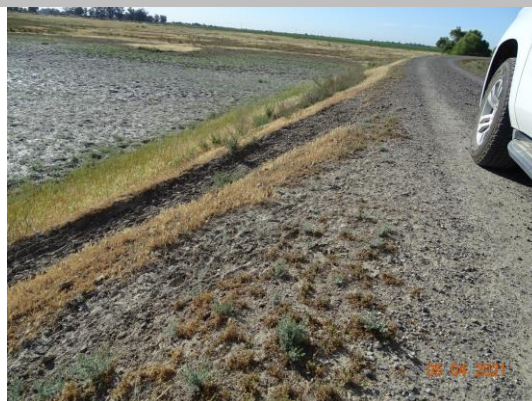
Photo 1 of 1 : SP\_2021\_NA0010\_118\_104\_20210517\_00303.jpg

LM Start	3.06	Rating **	M	Issue No.	104
LM End	3.06	Issue Type +	Ma	Location *	LS
Category	Earthen Levee			GPS Latitude/Longitude	
				Start	End
Item	Animal Control			37.322499 °	37.322499 °
				-120.928986 °	-120.928986 °
DWR ID	DWR_NA0010_01_f_2017_104				
Comment Code					
A2 : Repair the levee slope damaged by livestock and prevent large animal access.					
Inspector Comment					
Slope damage caused by animal foot traffic.

Slope damage on the landside slope from livestock traffic. (Spring 2021)

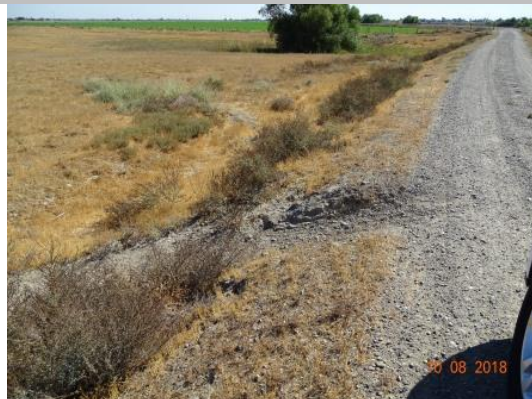
Photo 1 of 1 : SP\_2021\_NA0010\_118\_115\_20210308\_00022.jpg

LM Start	3.10	Rating **	M	Issue No.	115
LM End	3.10	Issue Type +	Ma	Location *	LS
Category	Earthen Levee			GPS Latitude/Longitude	
				Start	End
Item	Animal Control			37.321903 °	37.321903 °
				-120.928748 °	-120.928748 °
DWR ID	DWR_NA0010_01_f_2018_115				
Comment Code					
A2 : Repair the levee slope damaged by livestock and prevent large animal access.					
Inspector Comment					
Damage caused by livestock traffic.

View of erosion path looking downstream. (Fall 2018)

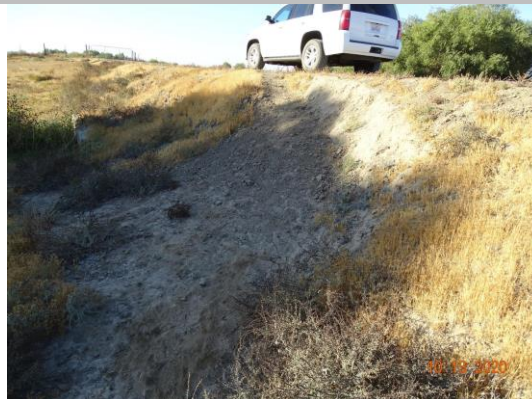
Photo 1 of 1 : SP\_2021\_NA0010\_118\_108\_20210308\_00016.jpg

LM Start	3.13	Rating **	M	Issue No.	108
LM End	3.13	Issue Type +	Ma	Location *	LS
Category	Earthen Levee			GPS Latitude/Longitude	
				Start	End
Item	Animal Control			37.321488 °	37.321488 °
				-120.928758 °	-120.928758 °
DWR ID	DWR_NA0010_01_s_2017_108				
Comment Code					
A2 : Repair the levee slope damaged by livestock and prevent large animal access.					
Inspector Comment					
Slope damage caused by animal traffic on landside toe.

View of landside slope damage by animal traffic. (Fall 2020)

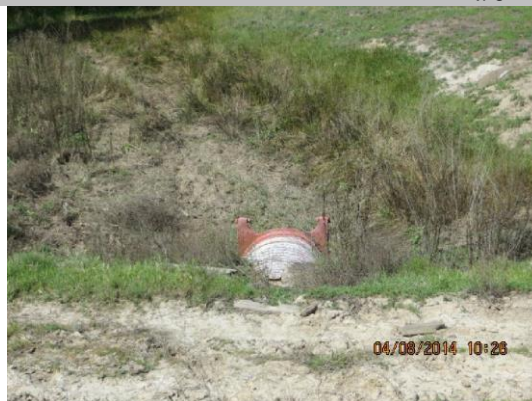
Photo 1 of 3 : UCIP\_SP\_2021\_62627\_60702.jpg

FS\_ID:62627  
DS\_ID:19574  
EP\_NO: N/A  
Repair Type: Non-Urgent  
Crossing Status: Found  
UCIP Comments: 10/06/2020 Pipe status is still Non-Urgent. No permit was found authorizing this encroachment. CVFPB will need to review crossing to determine owner. DWR DMP has not completed an internal inspection of the pipe but is scheduled for 2021. (B. Singh - GEI, O. Magana - DWR UCIP)04/08/2014 Some minor erosion around headwall on LS toe. (W. Wylie - DWR UCIP)  
FIELD\_STRUCT\_DESC: 36-inch corrugated metal gravity drainage pipe through the levee, 8 feet below the crown. Flap gate on the waterside (WS) end. Brass cap No. 100 bench mark (BM) on the headwall on the landside (LS). [Additional Reference(s): DWR Levee Log, 2002 (HLM 3.17), listed as a 36-inch corrugated metal pipe (CMP). USACE San Joaquin O&M Manual, Unit 601 Part 1 (SJR601.1), 1967, Revised 25 May 2011, (HLM 3.16), listed as a 36-inch CMP].

Pipe, Flapgate, and headwall on WS toe.

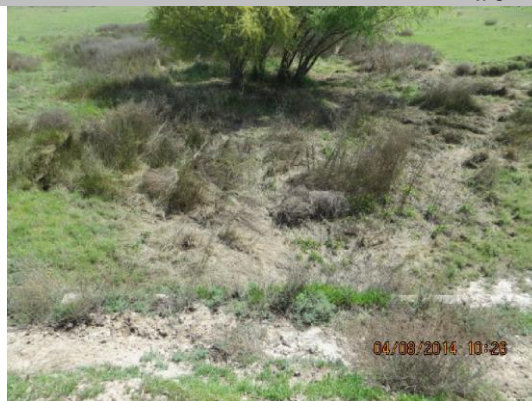
Photo 3 of 3 : UCIP\_SP\_2021\_62627\_60701.jpg

Pipe and headwall on LS toe.

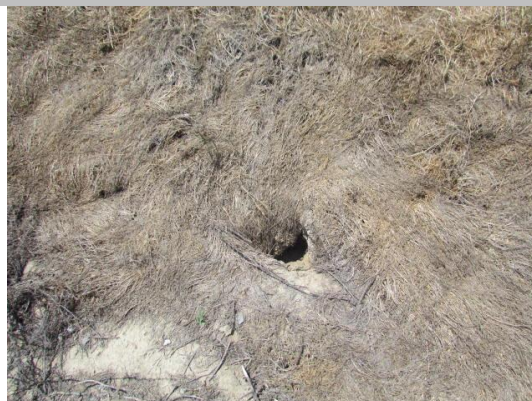
Photo 1 of 1 : SP\_2021\_NA0010\_118\_10\_20210308\_00004.jpg

LM Start	3.16	Rating **	A/W	Issue No.	10
LM End	3.16	Issue Type +	Ma	Location *	LS
Category	Earthen Levee			GPS Latitude/Longitude	
				Start	End
Item	Animal Control			37.321053 °	37.321053 °
				-120.928785 °	-120.928785 °
DWR ID	DWR_NA0010_01_s_2012_10				
Comment Code					
A3 : No rodents visible, but rodent burrows visible; need to backfill and compact or grout burrows.					
Inspector Comment

Looking at typical view of rodent holes on landward slope.

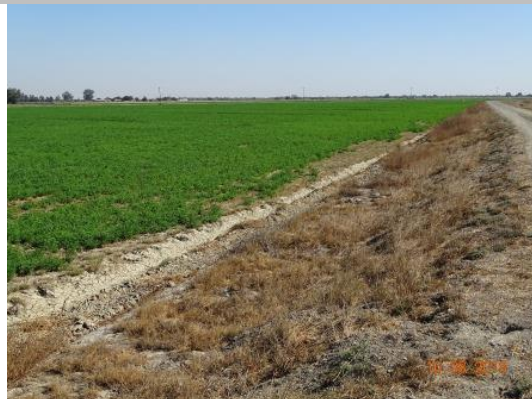
Photo 1 of 1 : SP\_2021\_NA0010\_118\_117\_20210308\_00024.jpg

LM Start	3.23	Rating **	M	Issue No.	117
LM End	3.90	Issue Type +	En	Location *	LS
Category	Earthen Levee			GPS Latitude/Longitude	
				Start	End
Item	Encroachments			37.320029 °	37.311311 °
				-120.928556 °	-120.927310 °
DWR ID	DWR_NA0010_01_f_2018_117				
Comment Code					
DT : Ditch					
Inspector Comment					
Earthen ditch along landside toe.

Earthen ditch along landside toe. (Fall 2018)

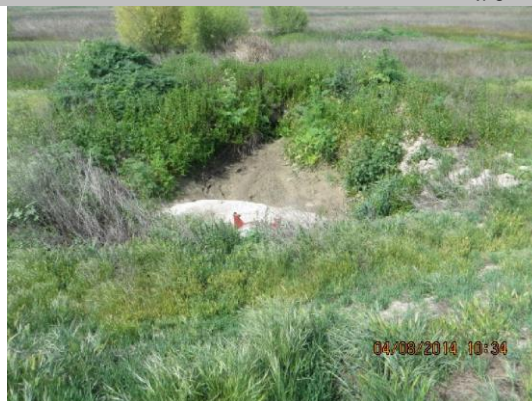
Photo 1 of 3 : UCIP\_SP\_2021\_62621\_60707.jpg

FS\_ID:62621  
DS\_ID:19575  
EP\_NO: N/A  
Repair Type: Urgent  
Crossing Status: Found  
UCIP Comments: 10/06/2020 Pipe status is still Urgent. Sinkhole present directly above LS toe headwall along pipe alignment. Pipe collapse visible from LS toe. No permit was found authorizing this encroachment. CVFPB will need to review crossing to determine owner. DWR DMP has not completed an internal inspection of the pipe but is scheduled for 2021. (B. Singh - GEI, O. Magana - DWR UCIP)11/01/2018 Pipe continues to rust through, causing the pipe to collapse on the LS. Sediment buildup visible from the LS inlet. Loss of soil just above the LS concrete headwall and along the LS slope. Crossing remains Urgent due to the levee slope issues and pipe failure through the levee. (O. Magana - DWR UCIP)07/19/2016 Same as previous inspection. Erosion present on LS slope. (O. Magana - DWR UCIP)04/08/2014 Pipe rusted through at Springline on LS toe. Flapgate blocked by sediment on WS toe. Heavy sediment on both ends of pipe. Need to contact owner to address issues. (W. Wylie - DWR UCIP)

FIELD\_STRUCT\_DESC: 36-inch corrugated metal gravity drainage pipe through the levee, 9.7 feet below the crown. Flap gate on the waterside (WS) end. Brass cap No. 100 bench mark (BM) on the headwall on the landside (LS). [Additional Reference(s): DWR Levee Log, 2002 (HLM 3.50), listed as a 36-inch corrugated metal pipe (CMP). USACE San Joaquin O&M Manual, Unit 601 Part 1 (SJR601.1), 1967, Revised 25 May 2011, (HLM 3.50), listed as a 36-inch CMP].  
FS Date: 10/6/2020

Pipe, headwall, and flapgate on WS toe.

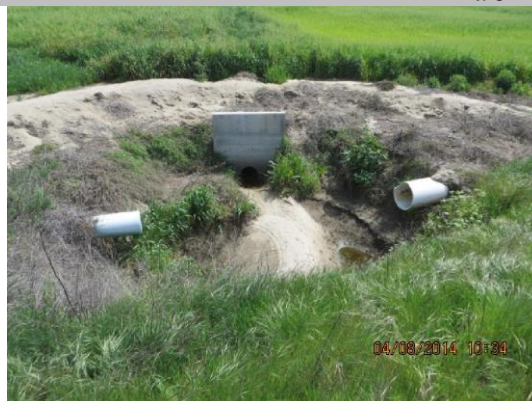
Photo 2 of 3 : UCIP\_SP\_2021\_62621\_60706.jpg

Pipe and headwall on LS toe.

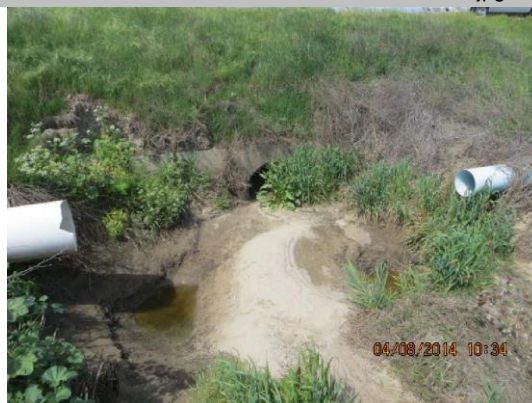
Photo 3 of 3 : UCIP\_SP\_2021\_62621\_60705.jpg

Pipe and headwall on LS toe.

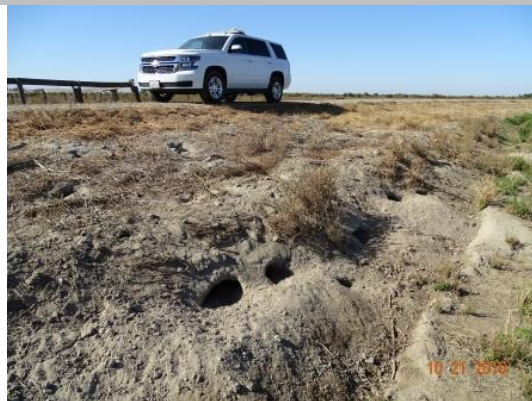
Photo 1 of 1 : SP\_2021\_NA0010\_118\_2\_20210308\_00001.jpg

LM Start	3.87	Rating **	U	Issue No.	2
LM End	3.90	Issue Type +	Ma	Location *	LS
Category	Earthen Levee			GPS Latitude/Longitude	
				Start	End
Item	Animal Control			37.311798 °	37.311341 °
				-120.927670 °	-120.927365 °
DWR ID	DWR_NA0010_01_s_2012_2				
Comment Code					
A1 : Exterminate rodents and backfill and compact or grout burrows.					
Inspector Comment					
Several rodent burrows are along this section of the levee.

View of rodent burrows in this section looking downstream. (Fall 2019)

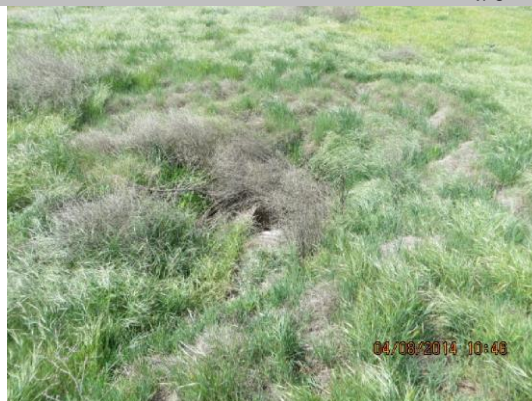
Photo 1 of 3 : UCIP\_SP\_2021\_62628\_60723.jpg

FS\_ID:62628  
DS\_ID:19576  
EP\_NO: N/A  
Repair Type: Non-Urgent  
Crossing Status: Found  
UCIP Comments: 10/06/2020 Pipe status is still Non-Urgent. Heavy siltation through length of pipe angled pipeline and at both inverts. Flapgate missing at WS toe. No permit was found authorizing this encroachment. CVFPB will need to review crossing to determine owner. DWR DMP has not completed an internal inspection of the pipe but is scheduled for 2021. (B. Singh - GEI, O. Magana - DWR UCIP)04/08/2014 Slide gate missing from WS. No closure device, but degrading of levee at Highway 140 is lower than pipe, so this does not appear to be a critical issue. Also dense vegetation limits the inspector's visibility to identify signs of pipe failure (leaks) along the slope. Recommend removing vegetation along pipe alignment to conduct proper inspection of structure and appurtenances. (W. Wylie - DWR UCIP)  
FIELD\_STRUCT\_DESC: 30-inch corrugated metal gravity drainage pipe through the levee, 3.5 feet below the crown. Flap gate on the waterside (WS) end. Brass cap No. 100 bench mark (BM) on the headwall on the landside (LS). [Additional Reference(s): DWR Levee Log, 2002 (HLM 3.95), listed as a 30-inch corrugated metal pipe (CMP). USACE San Joaquin O&M Manual, Unit 601 Part 1 (SJR601.1), 1967, Revised 25 May 2011, (HLM 3.95), listed as a 30-inch CMP].

Slide gate missing on WS toe with heavy vegetation camouflaging pipe

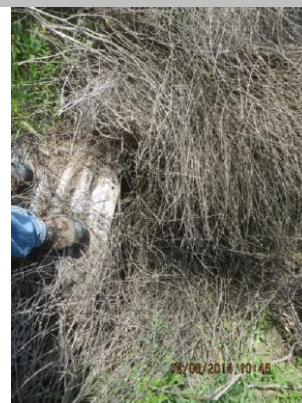
Photo 2 of 3 : UCIP\_SP\_2021\_62628\_60720.jpg

Slide gate missing on WS toe with heavy vegetation camouflaging pipe

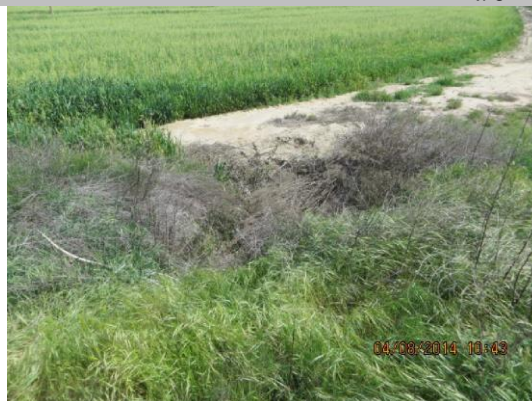
Photo 3 of 3 : UCIP\_SP\_2021\_62628\_60722.jpg

Concrete headwall in heavy vegetation at LS toe.

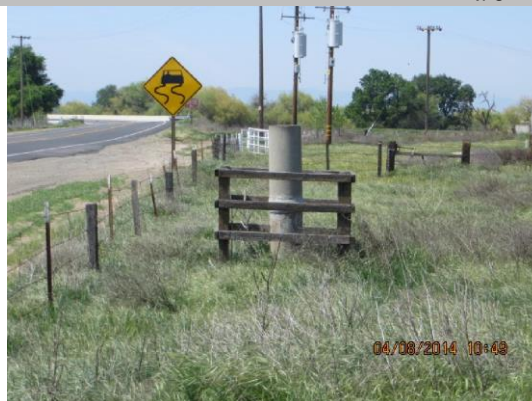
Photo 1 of 3 : UCIP\_SP\_2021\_62652\_60725.jpg

FS\_ID:62652  
 DS\_ID:19606  
 EP\_NO: N/A  
 Repair Type: Non-Urgent  
 Crossing Status: Indicator Found  
 UCIP Comments: 10/06/2020 No permit was found authorizing this encroachment. CVFPB will need to review crossing to determine owner. (B. Singh - GEI, O. Magana - DWR UCIP)04/08/2014 Need to contact owner to determine status of crossing inlet and outlet not found. (W. Wylie - DWR UCIP)  
 FIELD\_STRUCT\_DESC: 12-inch reinforced concrete irrigation discharge pipe through the levee, 3.5 feet below the crown. 12-inch concrete standpipe off each side of the levee. [Additional Reference(s): DWR Levee Log, 2002 (HLM 3.96), listed as a 12-inch concrete pipe].  
 FS Date: 10/6/2020

12-inch concrete standpipe off WS toe.

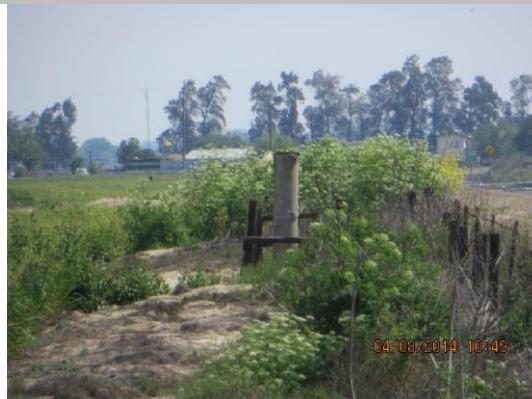
Photo 2 of 3 : UCIP\_SP\_2021\_62652\_60724.jpg

12-inch concrete standpipe off LS toe.

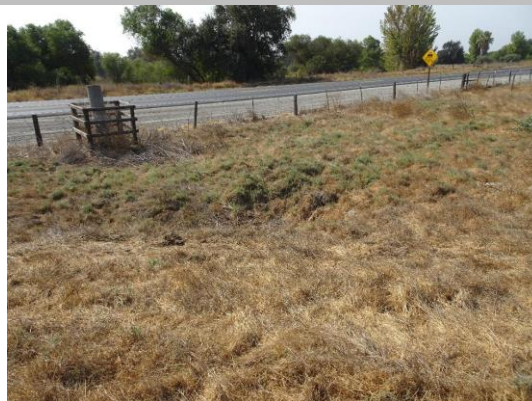
Photo 3 of 3 : UCIP\_SP\_2021\_62652\_90656.jpg

Overview of 12-inch standpipe at WS toe

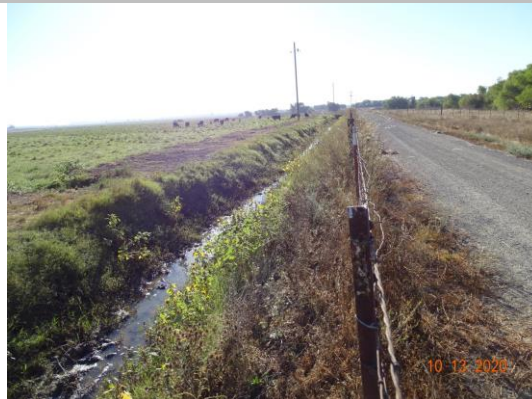
Photo 1 of 1 : SP\_2021\_NA0010\_118\_5\_20210308\_00002.jpg

LM Start	3.98	Rating **	U	Issue No.	5
LM End	4.05	Issue Type +	En	Location *	LS
Category	Earthen Levee			GPS Latitude/Longitude	
				Start	End
Item	Encroachments			37.310837 °	37.310003 °
				-120.926182 °	-120.925313 °
DWR ID	DWR_NA0010_01_s_2012_5				
Comment Code					
DT : Ditch					
Inspector Comment					
Irrigation ditch at landside toe.

Looking south at irrigation ditch at the landside toe. (Fall 2020)

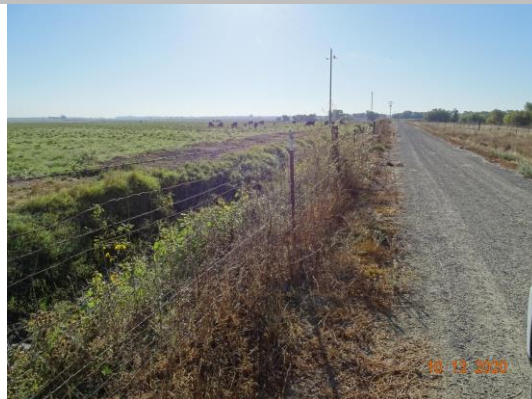
Photo 1 of 1 : SP\_2021\_NA0010\_118\_118\_20210308\_00025.jpg

LM Start	3.99	Rating **	M	Issue No.	118
LM End	4.25	Issue Type +	En	Location *	LS
Category	Earthen Levee			GPS Latitude/Longitude	
				Start	End
Item	Encroachments			37.310693 °	37.307895 °
				-120.926024 °	-120.922935 °
DWR ID	DWR_NA0010_01_f_2018_118				
Comment Code					
FE : Fence					
Inspector Comment					
Fence along landside toe.

View of fence on the landside shoulder and toe. (Fall 2020)

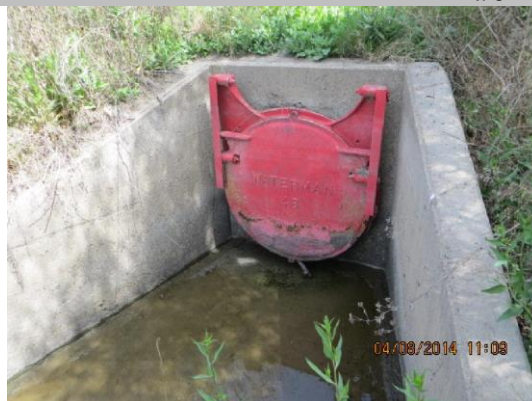
Photo 1 of 3 : UCIP\_SP\_2021\_62651\_60730.jpg

Comment Code						
Inspector Comment						
FS_ID:62651 DS_ID:19607 EP_NO: N/A Repair Type: Non-Urgent Crossing Status: Found UCIP Comments: 10/20/2020 Barbed wire inhibiting access to pipe at LS toe. Unpermitted modifications made to structure. Recommend new DSID and removal for seemingly abandoned 12" metal pipe through levee, approximately 1 foot below crown at CLM 4.131. Visible at LS structure. Recommend DMP inspection. No permit was found authorizing these encroachments. CVFPB will need to review crossing to determine owner(s). (B. Singh - GEI, O. Magana - DWR UCIP)04/08/2014 Pipe appears sleeved with a 12-inch steel pipe with a slide gate at the LS toe. No identified authorization for changes to this crossing. Need to contact owner to obtain additional information about the modifications to crossing. (W. Wylie - DWR UCIP) FIELD_STRUCT_DESC: 48-inch corrugated metal gravity drainage pipe through the levee, 14 feet below the crown. Flap gate on the waterside (WS) end. Brass cap No. 90 bench mark (BM) on the headwall on the landside (LS). [Additional Reference(s): DWR Levee Log, 2002 (HLM 4.16), listed as a 48-inch pipe. USACE San Joaquin O&M Manual, Unit 601 Part 1 (SJR601.1), 1967, Revised 25 May 2011, (HLM 4.16), listed as a 48-inch corrugated metal pipe (CMP)]. FS Date: 10/20/2020

Concrete headwall and 48-inch flapgate visible on WS toe.

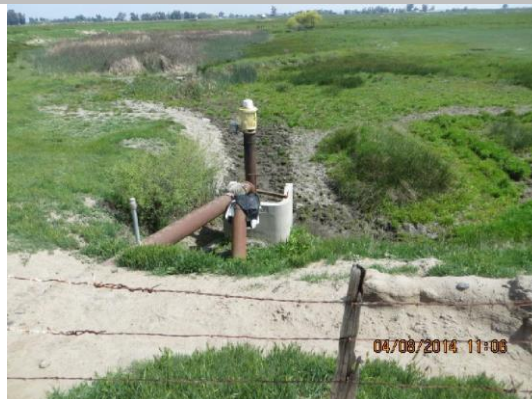
Photo 2 of 3 : UCIP\_SP\_2021\_62651\_60731.jpg

Assumed pipe exists under pump at LS toe.

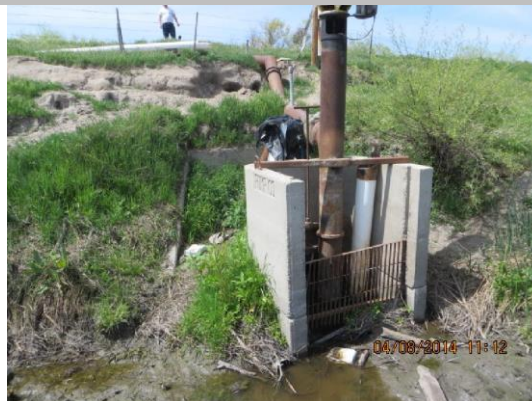
Photo 3 of 3 : UCIP\_SP\_2021\_62651\_60729.jpg

Concrete inlet, slidegate, and concrete headwall at LS toe.

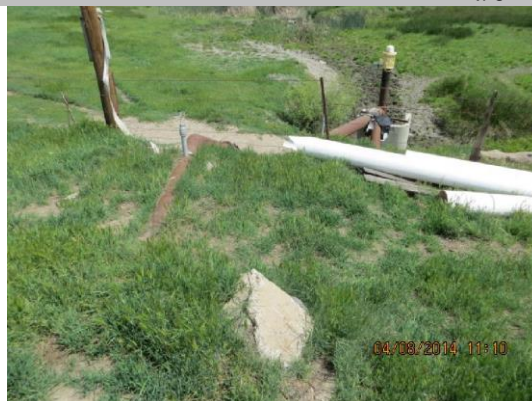
Photo 1 of 3 : UCIP\_SP\_2021\_62631\_71320.jpg

Comment Code						
Inspector Comment						
FS_ID:62631 DS_ID:24866 EP_NO: N/A Repair Type: Non-Urgent Crossing Status: Found UCIP Comments: 10/20/2020 Barbed wire inhibited access to LS toe and pipe. Pipe status is still Non-Urgent. No permit was found authorizing this encroachment. CVFPB will need to review crossing to determine owner. (B. Singh - GEI, O. Magana - DWR UCIP)04/08/2014 Need to contact owner to get details of crossing. (W. Wylie - DWR UCIP) FIELD_STRUCT_DESC: 12-inch steel drainage discharge pipe through the levee, 2.5 feet below the crown. 12-inch steel pipe, vent, and pump on stand visible on the landside (LS) slope. 10-inch polyvinyl chloride (PVC) pipe visible on the waterside (WS) slope. FS Date: 10/20/2020

View of pipe visible on landward side.

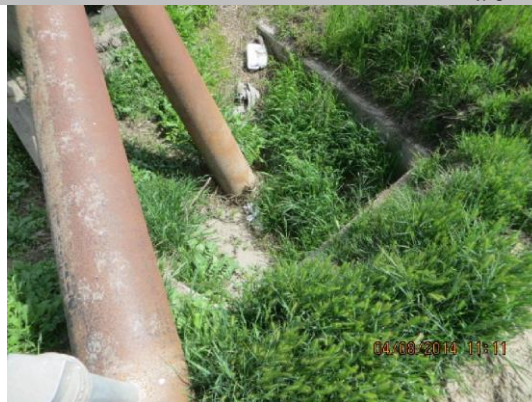
Photo 2 of 3 : UCIP\_SP\_2021\_62631\_71319.jpg

Pipe through existing 48 inch pipe.

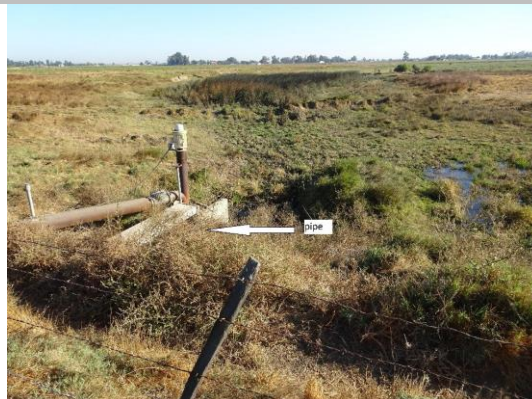
Photo 3 of 3 : UCIP\_SP\_2021\_62631\_90667.jpg

Location of pipe. Inspection inhibited by barbed wire fencing and dense vegetation

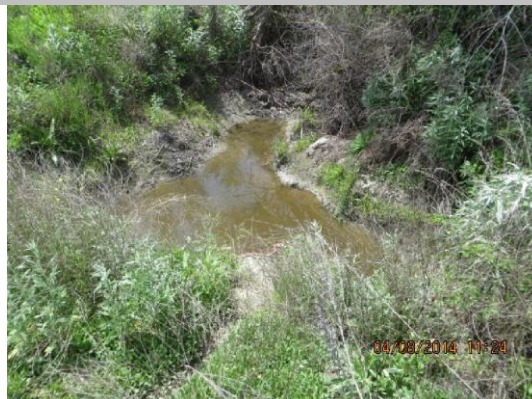
Photo 1 of 3 : UCIP\_SP\_2021\_62632\_60733.jpg

FS\_ID:62632  
DS\_ID:19608  
EP\_NO: N/A  
Repair Type: Non-Urgent  
Crossing Status: Found  
UCIP Comments: 10/20/2020 Fence and dense vegetation inhibiting slope inspection. Burrowing observed on LS and WS slopes. Pipe status is still Non-Urgent. No permit was found authorizing this encroachment. CVFPB will need to review crossing to determine owner. DWR DMP has not completed an internal inspection of the pipe but is scheduled for 2021. (B. Singh - GEI, O. Magana - DWR UCIP)04/08/2014 Dense vegetation and fence limits the inspector's visibility to identify signs of pipe failure (leaks) along the landward side. Recommend obtaining access to landward toe and removing vegetation along pipe alignment to conduct proper inspection of structure and appurtenances. (W. Wylie - DWR UCIP)  
FIELD\_STRUCT\_DESC: 24-inch corrugated metal gravity drainage pipe through the levee, 11.9 feet below the crown. Flap gate on the waterside (WS) end. Brass cap No. 90 bench mark (BM) on the headwall on the landside (LS). [Additional Reference(s): DWR Levee Log, 2002 (HLM 4.27), listed as a 24-inch corrugated metal pipe (CMP). USACE San Joaquin O&M Manual, Unit 601 Part 1 (SJR601.1), 1967, Revised 25 May 2011, (HLM 4.27), listed as a 24-inch CMP].

Pipe, flapgate, and headwall visible at WS toe.

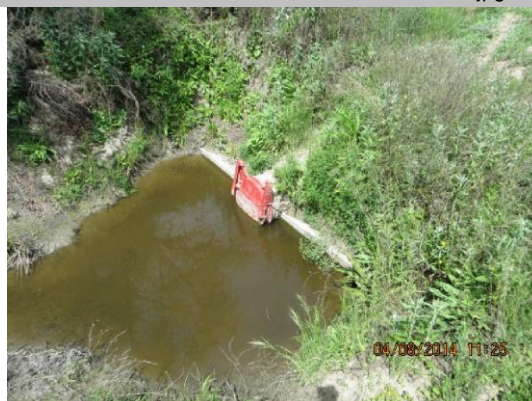
Photo 2 of 3 : UCIP\_SP\_2021\_62632\_60732.jpg

Pipe, flapgate, and headwall visible at WS toe.

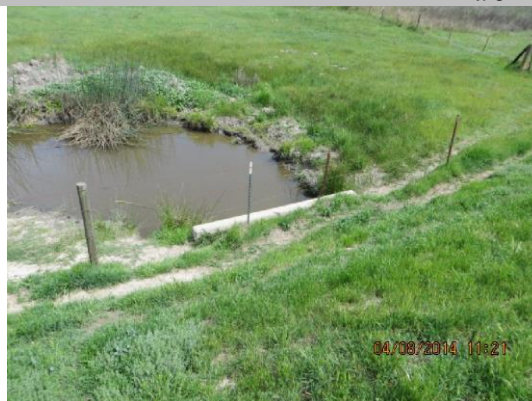
Photo 3 of 3 : UCIP\_SP\_2021\_62632\_60734.jpg

Concrete headwall at LS toe.

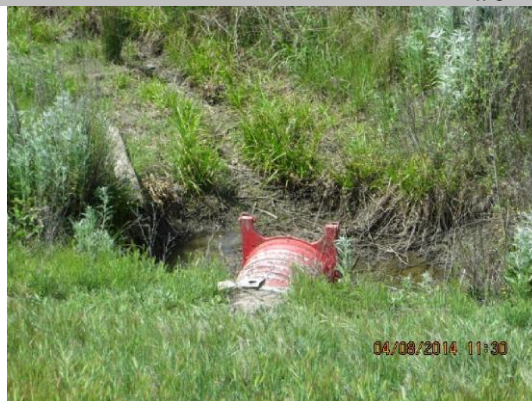
Photo 1 of 3 : UCIP\_SP\_2021\_62633\_60737.jpg

FS\_ID:62633  
DS\_ID:19609  
EP\_NO: N/A  
Repair Type: Urgent  
Crossing Status: Found  
UCIP Comments: 10/20/2020 Pipe status is still Urgent. DWR DMP has found integrity issues, LOF between 4 and 5. Crossing will be monitored until funding becomes available for rehabilitation or removal. Evidence of landslide of LS slope from crown. No permit was found authorizing this encroachment. CVFPB will need to review crossing to determine owner. (B. Singh - GEI, O. Magana - DWR UCIP)04/08/2014 Dense vegetation limits the inspector's visibility to identify signs of pipe failure (leaks) along the waterward side. Recommend removing vegetation along pipe alignment to conduct proper inspection of structure and appurtenances. (W. Wylie - DWR UCIP)  
FIELD\_STRUCT\_DESC: 24-inch corrugated metal gravity drainage pipe through the levee, 10 feet below the crown. Flap gate on the waterside (WS) end. Brass cap No. 90 bench mark (BM) on the headwall on the landside (LS). [Additional Reference(s): DWR Levee Log, 2002 (HLM 4.73), listed as a 24-inch corrugated metal pipe (CMP). USACE San Joaquin O&M Manual, Unit 601 Part 1 (SJR601.1), 1967, Revised 25 May 2011, (HLM 4.72), listed as a 24-inch CMP].

Pipe, flapgate, and headwall on WS toe.

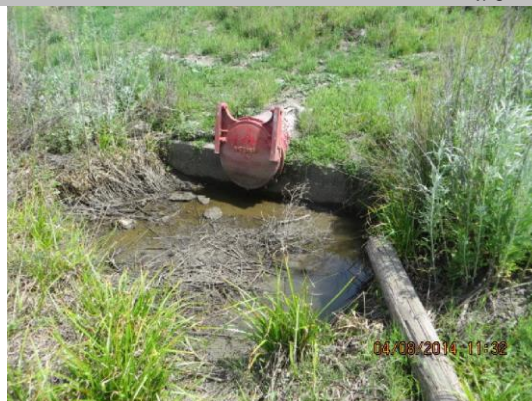
Photo 2 of 3 : UCIP\_SP\_2021\_62633\_60738.jpg

Pipe, flapgate, and headwall on WS toe.

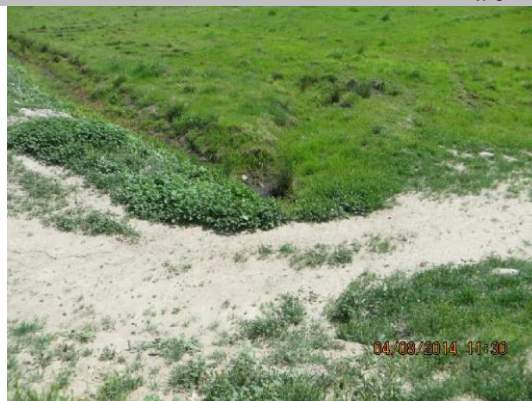
Photo 3 of 3 : UCIP\_SP\_2021\_62633\_60736.jpg

Pipe and concrete headwall on LS toe.
