# Flood Control Project Maintenance Levee Inspections LMA District Cover Sheet

## Lower San Joaquin Levee District

**Flood Control Project Maintenance  
Levee Inspections  
Unit Cover Sheet**

Waterway			Bank	Unit Miles
Unit No. 01 San Joaquin River			Right	22.52
	Spring (March - May)	Summer (June - August)	(September - November) Fall	Winter (December - February)
Unit Maintenance Rating (Fall Only)				
Date of Inspection	5/4/2021 - 5/4/2021			
DWR Inspector	Corey Fujitani			
Accompanied By

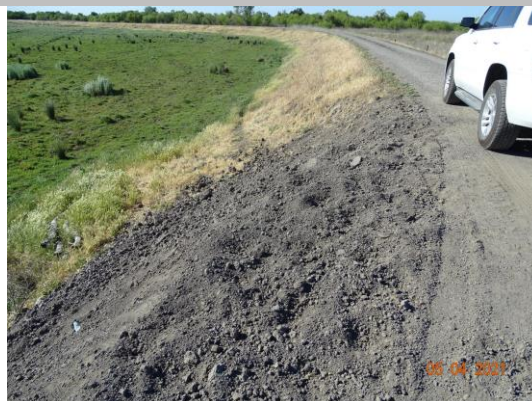
Photo 1 of 1 : SP\_2021\_NA0010\_118\_9\_20210517\_00304.jpg

LM Start	4.69	Rating **	A/W	Issue No.	9
LM End	4.69	Issue Type +	Ma	Location *	LS
Category	Earthen Levee			GPS Latitude/Longitude	
				Start	End
Item	Animal Control			37.302398 °	37.302398 °
				-120.920920 °	-120.920920 °
DWR ID	DWR_NA0010_01_s_2013_9				
Comment Code					
A2 : Repair the levee slope damaged by livestock and prevent large animal access.					
Inspector Comment					
Damage has been repaired. Backfill appears loosely compacted, monitor for potential settlement.

View of repaired slope damage on the landside. (Spring 2021)

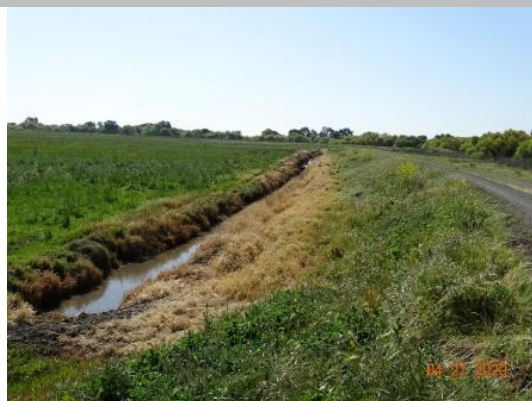
Photo 1 of 1 : SP\_2021\_NA0010\_118\_107\_20210308\_00015.jpg

LM Start	4.77	Rating **	M	Issue No.	107
LM End	5.32	Issue Type +	En	Location *	LS
Category	Earthen Levee			GPS Latitude/Longitude	
				Start	End
Item	Encroachments			37.301269 °	37.300396 °
				-120.920660 °	-120.912625 °
DWR ID	DWR_NA0010_01_s_2019_107				
Comment Code					
DT : Ditch					
Inspector Comment

Looking upstream at an irrigation ditch along the landside toe. (Spring 2020)

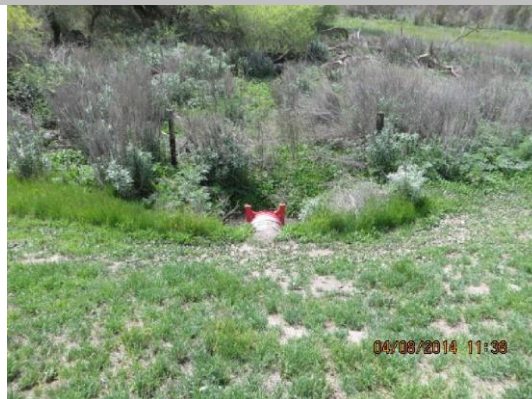
Photo 1 of 3 : UCIP\_SP\_2021\_62634\_60740.jpg

Comment Code					
Inspector Comment					
FS_ID:62634 DS_ID:19610 EP_NO: N/A Repair Type: Non-Urgent Crossing Status: Found UCIP Comments: 10/20/2020 Pipe not visible on LS, high vegetation limiting inspections. Pipe status is still Non-Urgent. No permit was found authorizing this encroachment. CVFPB will need to review crossing to determine owner. DWR DMP has not completed an internal inspection of the pipe but is scheduled for 2021. (B. Singh - GEI, O. Magana - DWR UCIP)04/08/2014 Non-functional -- sediment buildup against flapgate and inlet buried at landward side. (W. Wylie - DWR UCIP) FIELD_STRUCT_DESC: 24-inch corrugated metal gravity drainage pipe through the levee, 8 feet below the crown. Flap gate on the waterside (WS) end. Brass cap No. 90 bench mark (BM) on the headwall on the landside (LS). [Additional Reference(s): DWR Levee Log, 2002 (HLM 5.06), listed as a 24-inch corrugated metal pipe (CMP). USACE San Joaquin O&M Manual, Unit 601 Part 1 (SJR601.1), 1967, Revised 25 May 2011, (HLM 5.05), listed as a 24-inch CMP]. FS Date: 10/20/2020

Flapgate and headwall visible at WS toe.

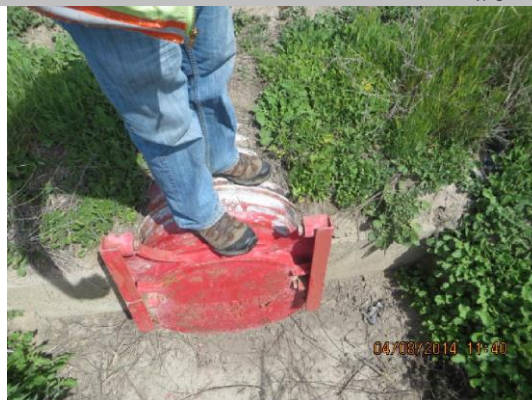
Photo 2 of 3 : UCIP\_SP\_2021\_62634\_60739.jpg

Flapgate and headwall visible at WS toe.

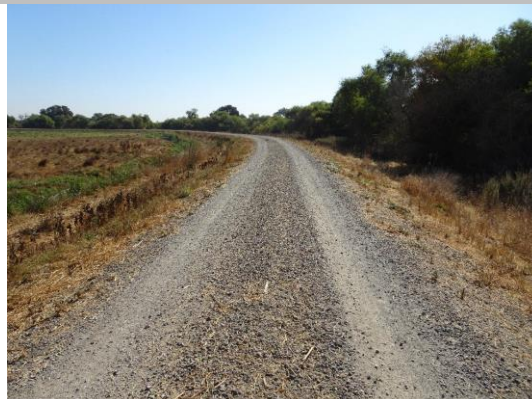
Photo 3 of 3 : UCIP\_SP\_2021\_62634\_90682.jpg

Overview of levee crown, looking US

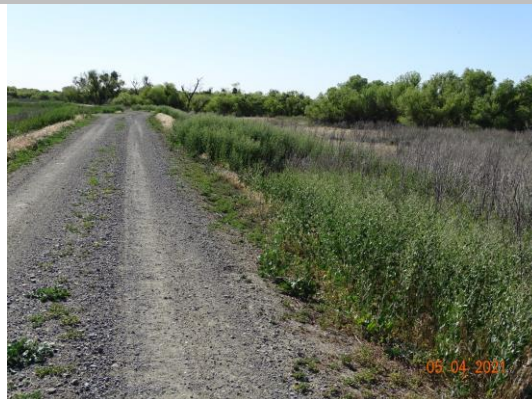
Photo 1 of 1 : SP\_2021\_NA0010\_118\_111\_20210517\_00305.jpg

LM Start	5.72	Rating **	U	Issue No.	111
LM End	6.66	Issue Type +	Ma	Location *	WS
Category	Earthen Levee			GPS Latitude/Longitude	
				Start	End
Item	Vegetation			37.304117 °	37.303327 °
				-120.907076 °	-120.891194 °
DWR ID	DWR_NA0010_01_s_2021_111				
Comment Code					
V1 : Control annual grass and weeds on the levee slopes and easements.					
Inspector Comment

Looking upstream along the waterside slope. (Spring 2021)

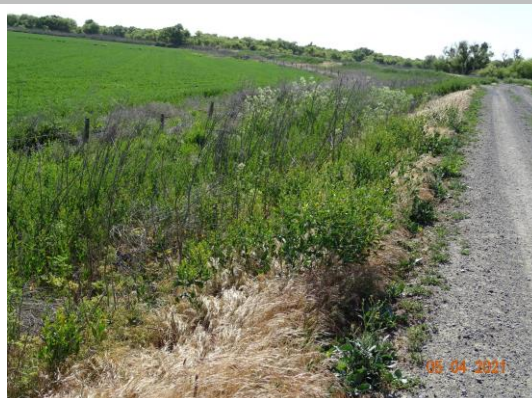
Photo 1 of 1 : SP\_2021\_NA0010\_118\_109\_20210517\_00306.jpg

LM Start	5.72	Rating **	U	Issue No.	109
LM End	6.67	Issue Type +	Ma	Location *	LS
Category	Earthen Levee			GPS Latitude/Longitude	
				Start	End
Item	Vegetation			37.304118 °	37.303278 °
				-120.907076 °	-120.891062 °
DWR ID	DWR_NA0010_01_s_2021_109				
Comment Code					
V1 : Control annual grass and weeds on the levee slopes and easements.					
Inspector Comment

View of vegetation on the landside slope. (Spring 2021)

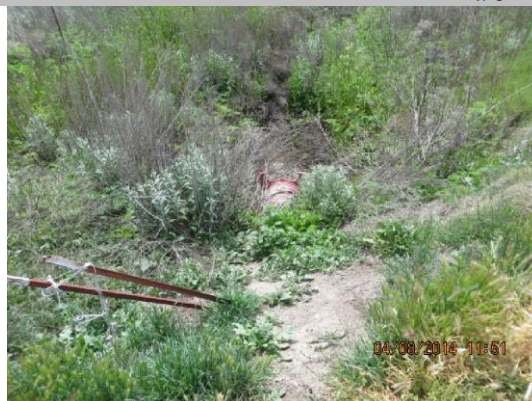
Photo 1 of 3 : UCIP\_SP\_2021\_62650\_60742.jpg

FS\_ID:62650  
DS\_ID:19611  
EP\_NO: N/A  
Repair Type: Non-Urgent  
Crossing Status: Found  
UCIP Comments: 10/20/2020 Pipe status is still non-urgent. Depression observed across levee crown, less than 6 inches in depth. Pipe at LS completely blocked by soil. Dense vegetation inhibiting proper inspection. Recommend soil and vegetation removal. No permit was found authorizing this encroachment. CVFPB will need to review crossing to determine owner. DWR DMP has not completed an internal inspection of the pipe but is scheduled for 2021. (B. Singh - GEI, O. Magana - DWR UCIP)04/08/2014 Dense vegetation limits the inspector's visibility to identify signs of pipe failure (leaks) along waterward and landward slopes. Recommend removing vegetation along pipe alignment to conduct proper inspection of structure and appurtenances. Landward side filled in with soil. Need to contact owner. If crossing is no longer used need to coordinate with CVFPB for proper abandonment. (W. Wylie - DWR UCIP)

Pipe, concrete headwall, and flapgate visible on WS toe.

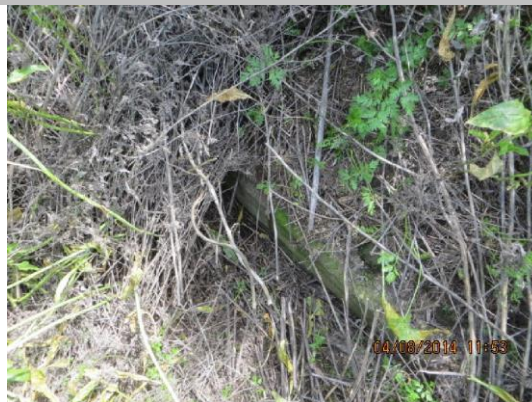
Photo 2 of 3 : UCIP\_SP\_2021\_62650\_60741.jpg

Top of concrete headwall just visible on LS toe.

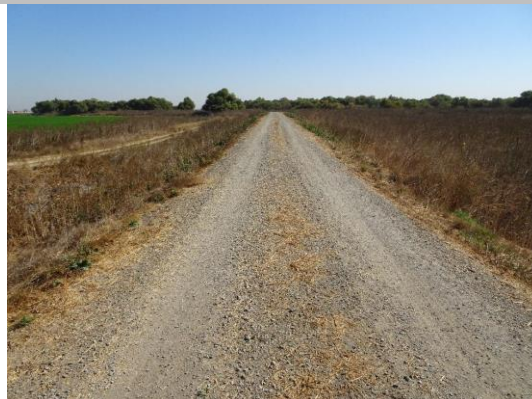
Photo 3 of 3 : UCIP\_SP\_2021\_62650\_90689.jpg

Overview of levee crown, looking US

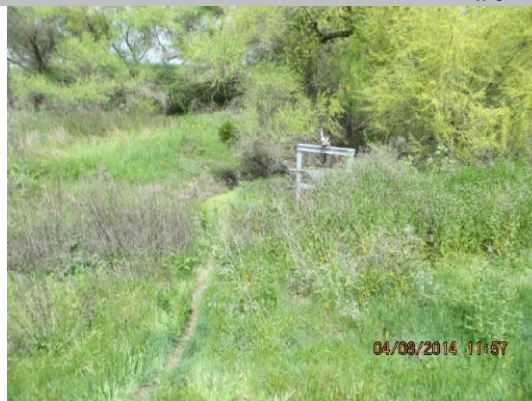
Photo 1 of 3 : UCIP\_SP\_2021\_62636\_60745.jpg

Comment Code						
Inspector Comment						
FS_ID:62636 DS_ID:19612 EP_NO: N/A Repair Type: Non-Urgent Crossing Status: Found UCIP Comments: 10/20/2020 Dense vegetation inhibited proper inspections. Recommend vegetation removal. Pipe angled through levee. Scour observed on LS toe surrounding headwall. Pipe status is still Non-Urgent. No permit was found authorizing this encroachment. CVFPB will need to review crossing to determine owner. DWR DMP has not completed an internal inspection of the pipe but is scheduled for 2021. (B. Singh - GEI, O. Magana - DWR UCIP)04/08/2014 Dense vegetation limits the inspector's visibility to identify signs of pipe failure (leaks) along waterward and landward slopes. Recommend removing vegetation along pipe alignment to conduct proper inspection of structure and appurtenances. Pipe completely blocked by soil on LS toe due to animal activity. Slide gate blocked open. (W. Wylie - DWR UCIP) FIELD_STRUCT_DESC: 48-inch corrugated metal gravity drainage pipe through the levee, 13.1 feet below the crown. Walkway to slide gate at the concrete headwall on the landside (LS) toe. Flap gate at the concrete headwall on the waterside (WS) toe. Brass cap No. 90 bench mark (BM) on the headwall on the LS. Pipe crosses the levee at an angle. [Additional Reference(s): DWR Levee Log, 2002 (HLM 6.13), listed as a 48-inch corrugated metal pipe (CMP). USACE San Joaquin O&M Manual, Unit 601 Part 1 (SJR601.1), 1967, Revised 25 May 2011, (HLM 6.13), listed as a 48-inch CMP]. FS Date: 10/20/2020

Slidegate at LS toe.

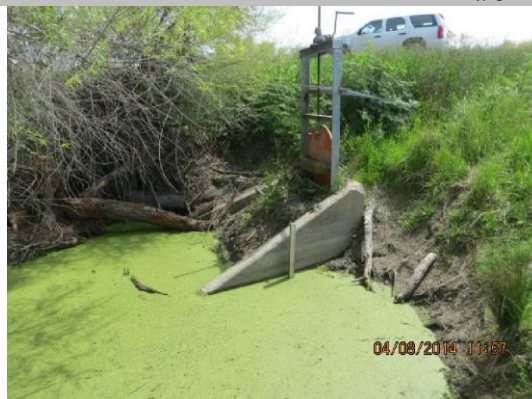
Photo 2 of 3 : UCIP\_SP\_2021\_62636\_60744.jpg

Pipe, concrete headwall, slidegate, and metal walkway on LS toe.

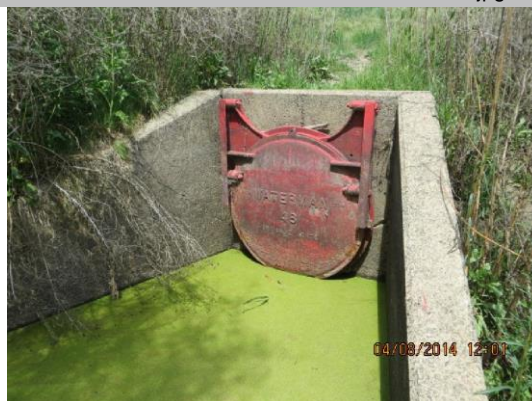
Photo 3 of 3 : UCIP\_SP\_2021\_62636\_60743.jpg

Flapgate on concrete headwall at WS toe.

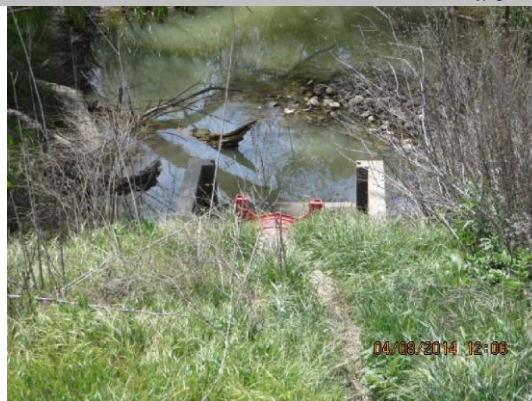
Photo 1 of 3 : UCIP\_SP\_2021\_62638\_60762.jpg

FS\_ID:62638  
DS\_ID:19613  
EP\_NO: N/A  
Repair Type: Non-Urgent  
Crossing Status: Found  
UCIP Comments: 10/20/2020 Pipe status is still Non-Urgent. Dense vegetation on WS toe, recommend removal for proper inspection. Minor scour visible on LS toe near standpipe. No permit was found authorizing this encroachment. CVFPB will need to review crossing to determine owner. DWR DMP has not completed an internal inspection of the pipe but is scheduled for 2021. (B. Singh - GEI, O. Magana - DWR UCIP)04/08/2014 Dense vegetation limits the inspector's visibility to identify signs of pipe failure (leaks) along the slope. Recommend removing vegetation along pipe alignment to conduct proper inspection of structure and appurtenances. (W. Wylie - DWR UCIP)  
FIELD\_STRUCT\_DESC: 24-inch corrugated metal gravity drainage pipe through the levee, 9.5 feet below the crown. Flap gate on the waterside (WS) end. Slide gate on the landside (LS) end next to a 48-inch concrete riser with walkway over the top. Brass cap No. 90 bench mark (BM) on the headwall on the LS. [Additional Reference(s): DWR Levee Log, 2002 (HLM 6.44), listed as a 24-inch corrugated metal pipe (CMP). USACE San Joaquin O&M Manual, Unit 601 Part 1 (SJR601.1), 1967, Revised 25 May 2011, (HLM 6.40), listed as a 24-inch CMP].

Pipe, flapgate, and concrete headwall on WS toe.

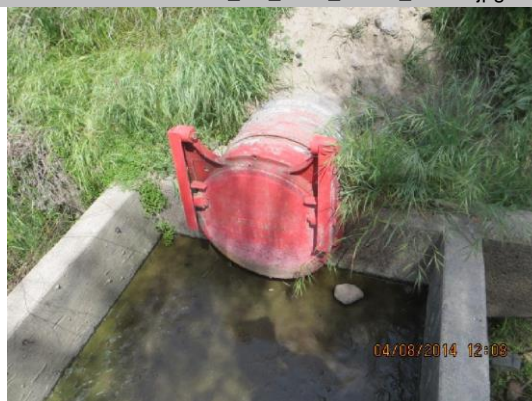
Photo 2 of 3 : UCIP\_SP\_2021\_62638\_60760.jpg

Pipe, flapgate, and concrete headwall on WS toe.

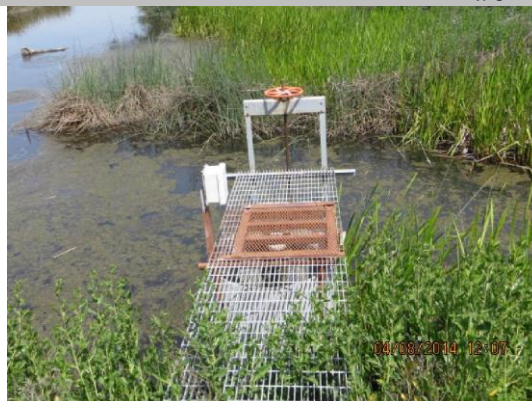
Photo 3 of 3 : UCIP\_SP\_2021\_62638\_60761.jpg

Metal walkway over concrete standpipe next to slide gate on LS toe.

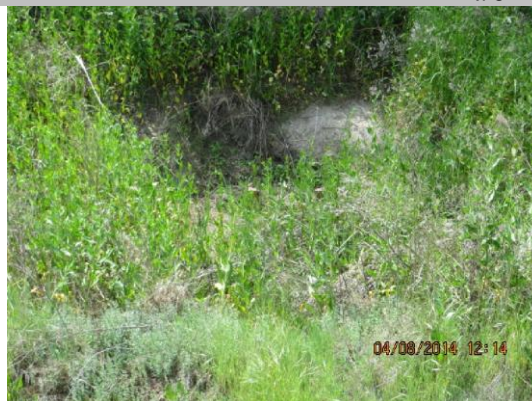
Photo 1 of 3 : UCIP\_SP\_2021\_62639\_60764.jpg

FS\_ID:62639  
DS\_ID:19614  
EP\_NO: N/A  
Repair Type: Non-Urgent  
Crossing Status: Found  
UCIP Comments: 10/20/2020 Pipe status is still Non-Urgent, but DMP inspection is recommended. Dense vegetation inhibits inspection of pipe at LS toe, and both slopes. No permit was found authorizing this encroachment. CVFPB will need to review crossing to determine owner. (B. Singh - GEI, O. Magana - DWR UCIP)7/19/2016 Same as previous inspection. Outlet and inlet are under water. (O. Magana - DWR UCIP)4/08/2014 Flapgate blocked by sedimentation at WS toe. Dense vegetation limits the inspector's visibility to identify signs of pipe failure (leaks) along the slope. Recommend removing vegetation along pipe alignment to conduct proper inspection of structure and appurtenances. Also recommend clearing vegetation from both waterward and landward toe. (W. Wylie - DWR UCIP)  
FIELD\_STRUCT\_DESC: 24-inch corrugated metal gravity drainage pipe through the levee, 9.8 feet below the crown. Wooden fence around a 4-foot by 4-foot drop inlet on the landside (LS) toe. Flap gate on the waterside (WS) end. Brass cap No. 90 bench mark (BM) on the headwall on the LS. [Additional Reference(s): DWR Levee Log, 2002 (HLM 6.65), listed as a 24-inch corrugated metal pipe (CMP). USACE San Joaquin O&M Manual, Unit 601 Part 1 (SJR601.1), 1967, Revised 25 May 2011, (HLM 6.64), listed as a 24-inch CMP].

Pipe and flapgate visible on WS toe.

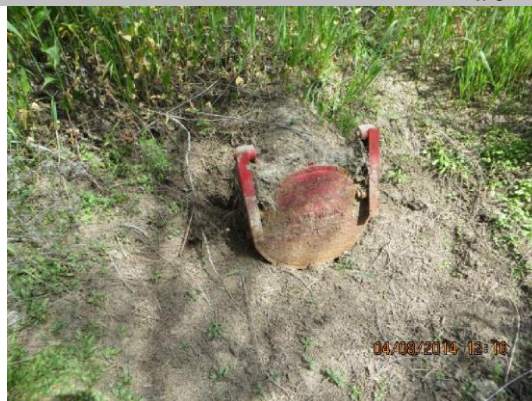
Photo 2 of 3 : UCIP\_SP\_2021\_62639\_60766.jpg

Pipe and flapgate visible at WS toe. Flapgate blocked by sedimentation on WS toe.

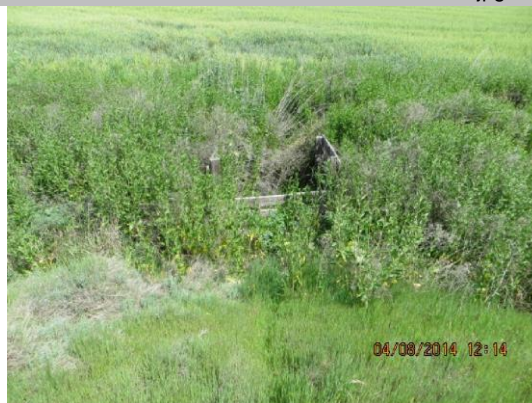
Photo 3 of 3 : UCIP\_SP\_2021\_62639\_60765.jpg

Wooden barrier around drop inlet on LS toe. Excess vegetation.

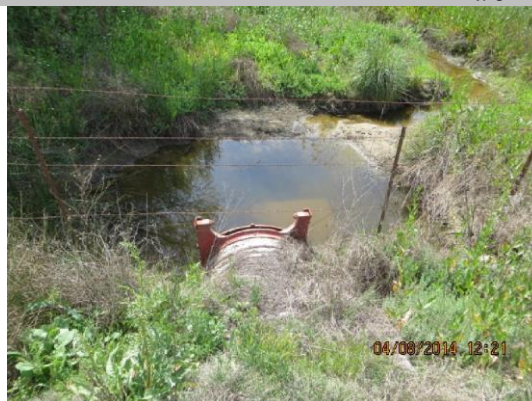
Photo 1 of 3 : UCIP\_SP\_2021\_62642\_60768.jpg

FS\_ID:62642  
DS\_ID:19615  
EP\_NO: N/A  
Repair Type: Urgent  
Crossing Status: Found  
UCIP Comments: 10/20/2020 Pipe status is Urgent. Surface erosion present on LS slope. Corrosion through pipe near flapgate and surface erosion at WS toe. Plastic sheeting was placed approximately 15 feet downstream of the pipe to prevent further erosion. Recommend DMP inspection. Crossing will continued to be monitored. No permit was found authorizing this encroachment. CVFPB will need to review crossing to determine owner. (B. Singh - GEI, O. Magana - DWR UCIP)7/19/2016 Potential LS slope damage--difficult to determine due to dense vegetation. Limited access on WS toe due to wire fence. (O. Magana - DWR UCIP)4/08/2014 Slide gate blocked by debris at LS toe. Flapgate won't close because of debris. Dense vegetation limits the inspector's visibility to identify signs of pipe failure (leaks) along the slope. Recommend removing vegetation along pipe alignment to conduct proper inspection of structure and appurtenances. (W. Wylie - DWR UCIP)

FIELD\_STRUCT\_DESC: 36-inch corrugated metal gravity drainage pipe through the levee, 10.3 feet below the crown. Slide gate on the landside (LS) toe. Flap gate on the waterside (WS) end. Brass cap No. 90 bench mark (BM) on the headwall on the LS. [Additional Reference(s): DWR Levee Log, 2002 (HLM 6.90), listed as a 36-inch corrugated metal pipe (CMP). USACE San Joaquin O&M Manual, Unit 601 Part 1 (SJR601.1), 1967, Revised 25 May 2011, (HLM 6.90), listed as a 36-inch CMP].  
FS Date: 10/20/2020

Pipe, headwall, and flapgate on WS toe.

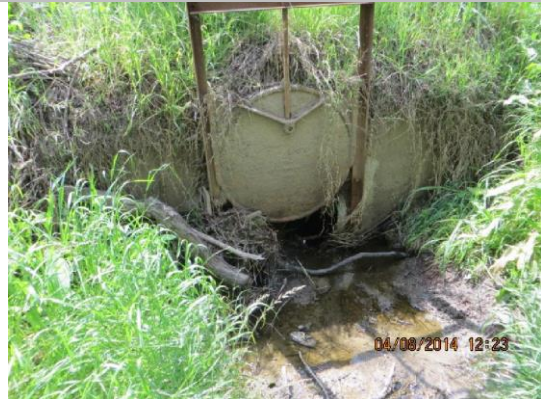
Photo 2 of 3 : UCIP\_SP\_2021\_62642\_60767.jpg

Pipe, concrete headwall, and slidegate on LS toe. Debris blocking closure of slidegate.

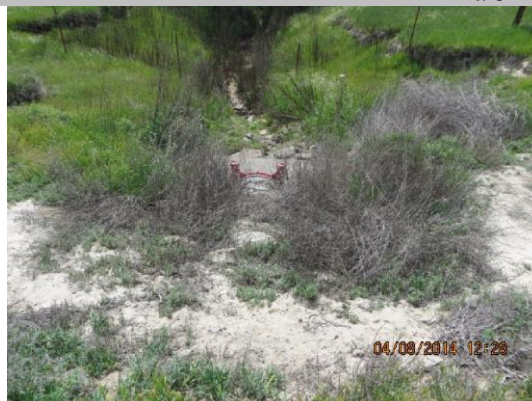
Photo 1 of 3 : UCIP\_SP\_2021\_62641\_60770.jpg

FS\_ID:62641  
DS\_ID:19616  
EP\_NO: N/A  
Repair Type: Urgent  
Crossing Status: Found  
UCIP Comments: 10/20/2020 Pipe status is still Urgent - recommend replacement. DWR DMP has found integrity issues, LOF between 5 and 6. Pipe deeply corroded. Crossing will be monitored until funding becomes available for removal. No permit was found authorizing this encroachment. CVFPB will need to review crossing to determine owner. (B. Singh - GEI, O. Magana - DWR UCIP)11/01/2018 Pipe continues to corrode through. Voids (undermining) along pipe invert are visible from the LS. Potential undermining caused by erosion under concrete apron on the WS. Crossing remains Urgent due to the pipe failure. (O. Magana - DWR UCIP)04/08/2014 Pipe failing and corroded through at LS toe. Need to contact owner to determine status of crossing. Also dense vegetation limits the inspector's visibility to identify signs of pipe failure (leaks) along the landward slope. Recommend removing vegetation along pipe alignment to conduct proper inspection of structure. (W. Wylie - DWR UCIP)

FIELD\_STRUCT\_DESC: 24-inch corrugated metal gravity drainage pipe through the levee, 5.1 feet below the crown. Flap gate on the waterside (WS) end. Brass cap No. 90 bench mark (BM) on the headwall on the landside (LS). [Additional Reference(s): DWR Levee Log, 2002 (HLM 7.22), listed as a 24-inch corrugated metal pipe (CMP). USACE San Joaquin O&M Manual, Unit 601 Part 1 (SJR601.1), 1967, Revised 25 May 2011, (HLM 7.21), listed as a 24-inch CMP].  
FS Date: 10/20/2020

Pipe, concrete headwall, and flapgate on WS toe.

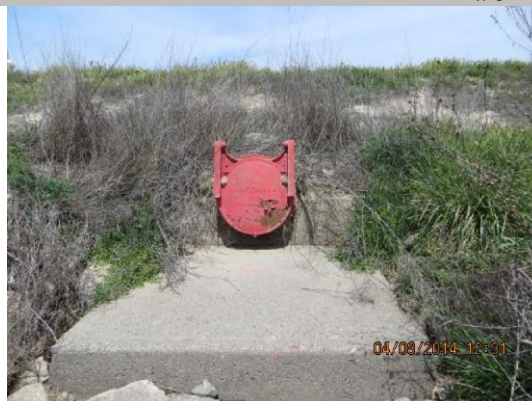
Photo 2 of 3 : UCIP\_SP\_2021\_62641\_60772.jpg

Flapgate and concrete headwall on WS toe.

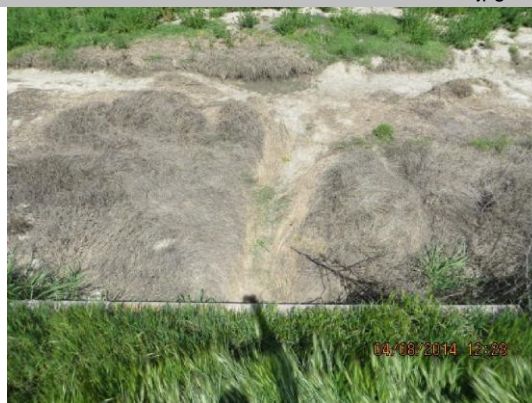
Photo 3 of 3 : UCIP\_SP\_2021\_62641\_60771.jpg

Pipe and Concrete headwall visible on LS toe.

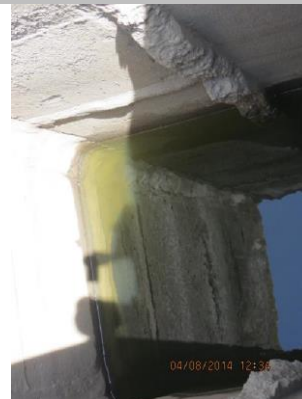
Photo 1 of 3 : UCIP\_SP\_2021\_62643\_60776.jpg

FS\_ID:62643  
DS\_ID:19617  
EP\_NO: 4425  
Repair Type: Non-Urgent  
Crossing Status: Found  
UCIP Comments: 10/20/2020 Pipe status is still Non-Urgent. No permit was found authorizing this encroachment. CVFPB will need to review crossing to determine owner. (B. Singh - GEI, O. Magana - DWR UCIP)04/08/2014 Recommend contacting owner to determine status of crossing. No pump was found on waterward side (riverbank). If crossing is no longer used need to coordinate with CVFPB for proper abandonment. (W. Wylie - DWR UCIP)  
FIELD\_STRUCT\_DESC: 24-inch concrete encased steel irrigation discharge pipe through the levee, 13.6 feet below the crown. Pipe encased in 6-inches of concrete through the levee. 5-foot by 7-foot concrete distribution box on the waterside (WS). 20-inch concrete standpipe at the landside (LS) toe. Pump on the riverbank, accessible by walkway platform, pump not found. Concrete cutoff walls around pipe in line with the levee shoulders. Pipe extends to 36-inch concrete pipes on both sides of the levee. (Plans to install an irrigation pipeline through the levee authorized under Permit No. 4425, 1964 - James J. Stevenson, a Corporation). [Additional Reference(s): DWR Levee Log, 2002 (HLM 7.33), listed as a 24-inch pipe].

Pipe visible under water in concrete box riser on WS toe.

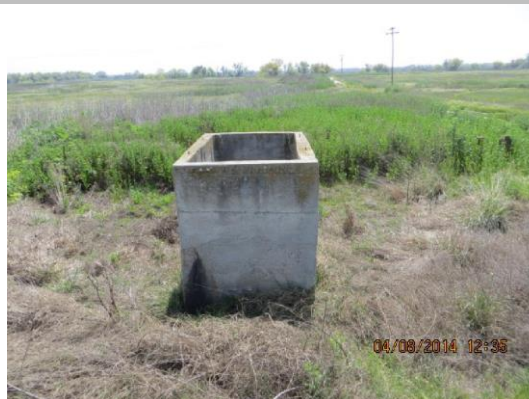
Photo 2 of 3 : UCIP\_SP\_2021\_62643\_60775.jpg

5'X7' concrete box riser on WS toe.

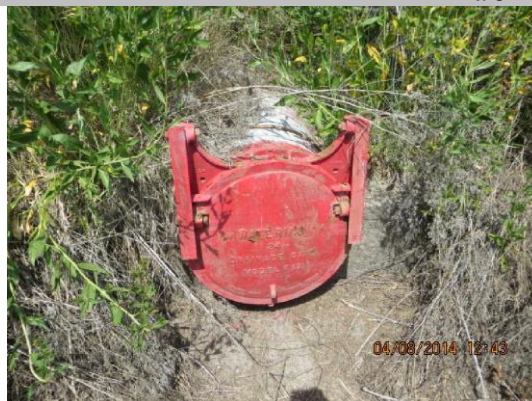
Photo 2 of 3 : UCIP\_SP\_2021\_62644\_60780.jpg

Pipe and flapgate visible on WS toe.

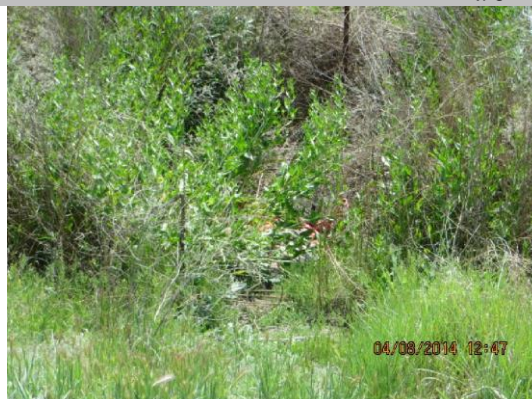
Photo 1 of 3 : UCIP\_SP\_2021\_62653\_60842.jpg

FS\_ID:62653  
DS\_ID:19619  
EP\_NO: N/A  
Repair Type: Urgent  
Crossing Status: Found  
UCIP Comments: 10/20/2020 Pipe status is Urgent. Sloughing observed above pipe and headwall on LS slope. DWR DMP has found integrity issues, LOF between 5 and 6. Crossing will be monitored until funding becomes available for removal. No permit was found authorizing this encroachment. CVFPB will need to review crossing to determine owner. (B. Singh - GEI, O. Magana - DWR UCIP)04/08/2014 Dense vegetation limits the inspector's visibility to identify signs of pipe failure (leaks) along the slope. Recommend removing vegetation along pipe alignment to conduct proper inspection of structure. (W. Wylie - DWR UCIP)  
FIELD\_STRUCT\_DESC: 24-inch corrugated metal gravity drainage pipe through the levee, 10 feet below the crown. Flap gate on the waterside (WS) end. Brass cap No. 80 bench mark (BM) on the headwall on the landside (LS). [Additional Reference(s): DWR Levee Log, 2002 (HLM 7.70), listed as a 24-inch corrugated metal pipe (CMP). USACE San Joaquin O&M Manual, Unit 601 Part 1 (SJR601.1), 1967, Revised 25 May 2011, (HLM 7.69), listed as a 24-inch CMP].

Flapgate and headwall at WS toe. Heavy vegetation on slopes.

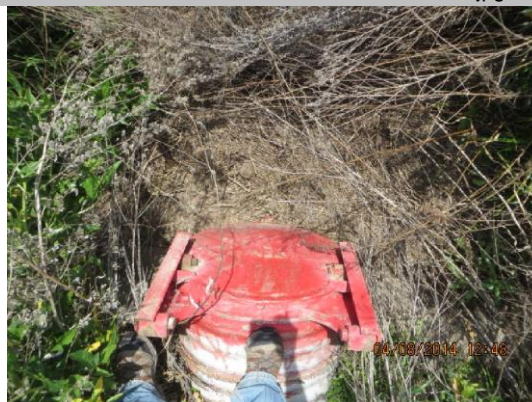
Photo 2 of 3 : UCIP\_SP\_2021\_62653\_60840.jpg

Flapgate and headwall at WS toe.

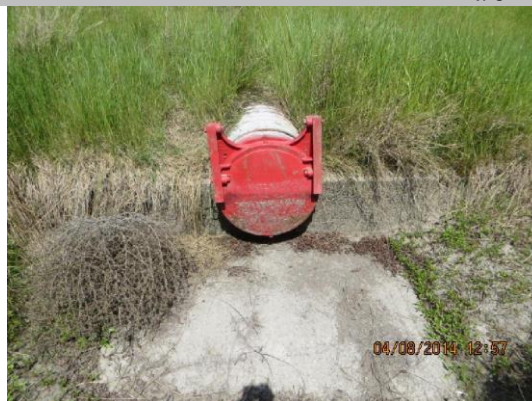
Photo 2 of 3 : UCIP\_SP\_2021\_62654\_60847.jpg

Pipe, Headwall, and flapgate at WS toe.

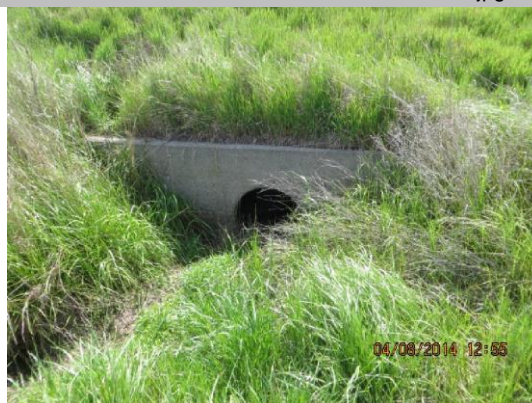
Photo 3 of 3 : UCIP\_SP\_2021\_62654\_60846.jpg

Pipe and concrete headwall on LS toe.

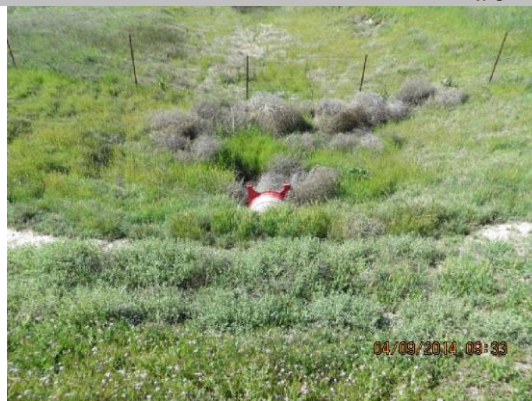
Photo 1 of 3 : UCIP\_SP\_2021\_62660\_60850.jpg

FS\_ID:62660  
DS\_ID:19621  
EP\_NO: N/A  
Repair Type: Urgent  
Crossing Status: Found  
UCIP Comments: 10/20/2020 Pipe status is Urgent. DWR DMP has found integrity issues, LOF between 4 and 5. Crossing will be monitored until funding becomes available for rehabilitation. No permit was found authorizing this encroachment. CVFPB will need to review crossing to determine owner. (B. Singh - GEI, O. Magana - DWR UCIP)04/09/2014 Dense vegetation limits the inspector's visibility to identify signs of pipe failure (leaks) along the slope. Recommend removing vegetation along pipe alignment to conduct proper inspection of structure. Sediment buildup at landward toe. (W. Wylie - DWR UCIP) FIELD\_STRUCT\_DESC: 24-inch corrugated metal gravity drainage pipe through the levee, 9.5 feet below the crown. Flap gate on the waterside (WS) end. Brass cap No. 80 bench mark (BM) on the headwall on the landside (LS). [Additional Reference(s): DWR Levee Log, 2002 (HLM 8.43), listed as a 24-inch corrugated metal pipe (CMP). USACE San Joaquin O&M Manual, Unit 601 Part 1 (SJR601.1), 1967, Revised 25 May 2011, (HLM 8.41), listed as a 24-inch CMP]. FS Date: 10/20/2020

Concrete headwall, pipe, and flapgate at WS toe.

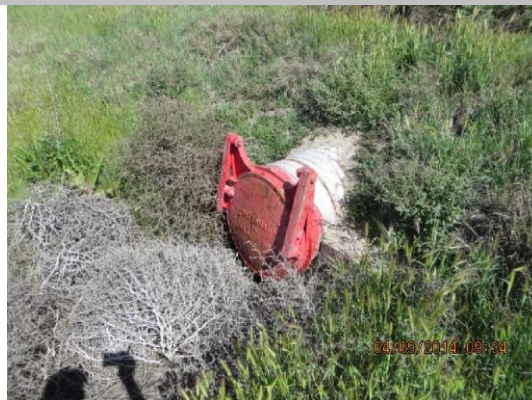
Photo 2 of 3 : UCIP\_SP\_2021\_62660\_60848.jpg

Concrete headwall, pipe, and flapgate at WS toe.

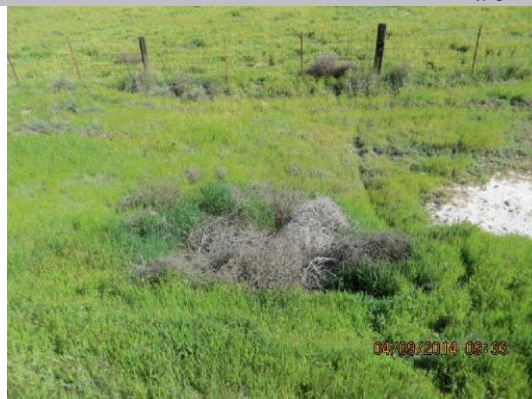
Photo 3 of 3 : UCIP\_SP\_2021\_62660\_60849.jpg

Pipe and concrete headwall at LS toe. Note heavy vegetation.

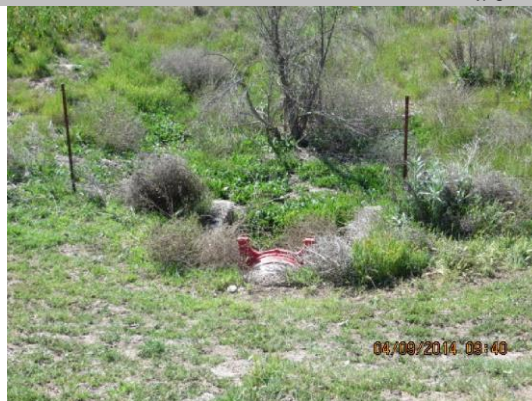
Photo 1 of 3 : UCIP\_SP\_2021\_62662\_60854.jpg

FS\_ID:62662  
DS\_ID:19622  
EP\_NO: N/A  
Repair Type: Non-Urgent  
Crossing Status: Found  
UCIP Comments: 10/20/2020 Pipe status is Non-Urgent. Large burrow hole observed approximately 100 feet downstream of the pipe, on LS shoulder of the levee crown. No permit was found authorizing this encroachment. CVFPB will need to review crossing to determine owner. DWR DMP has not found internal issues, LOF between 1 and 2. Recommend inspection in 5 years. (B. Singh - GEI, O. Magana - DWR UCIP)  
FIELD\_STRUCT\_DESC: 24-inch corrugated metal gravity drainage pipe through the levee, 9 feet below the crown. Flap gate on the waterside (WS) end. Brass cap No. 80 bench mark (BM) on the headwall on the landside (LS). [Additional Reference(s): DWR Levee Log, 2002 (HLM 8.62), listed as a 24-inch corrugated metal pipe (CMP). USACE San Joaquin O&M Manual, Unit 601 Part 1 (SJR601.1), 1967, Revised 25 May 2011, (HLM 8.61), listed as a 24-inch CMP].

Pipe, Flapgate, and headwall on WS toe.

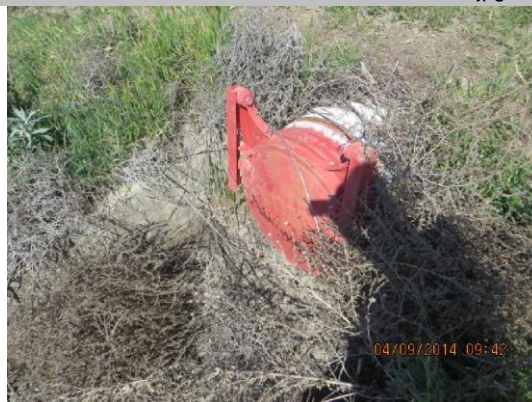
Photo 2 of 3 : UCIP\_SP\_2021\_62662\_60855.jpg

Pipe, Flapgate, and headwall on WS toe.

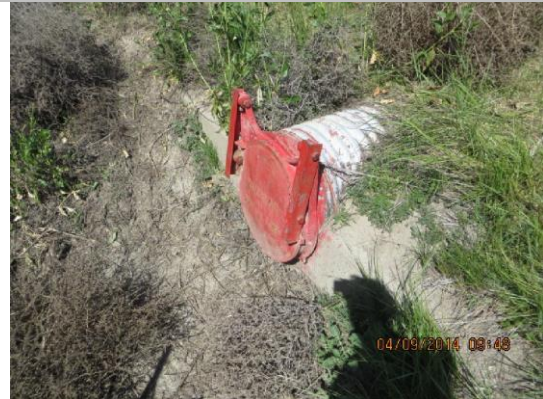
Photo 2 of 3 : UCIP\_SP\_2021\_62663\_60860.jpg

Pipe, flapgate, and headwall on WS toe.

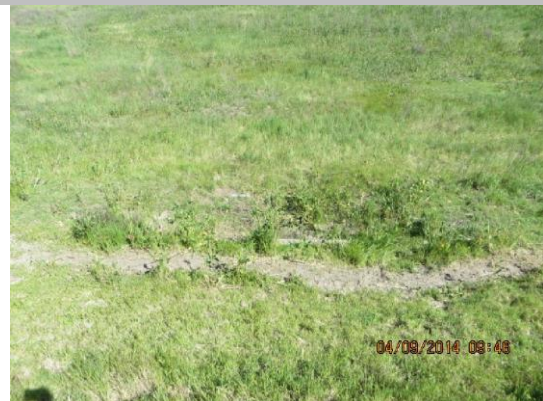
Photo 3 of 3 : UCIP\_SP\_2021\_62663\_60858.jpg

Pipe and headwall visible on LS toe.

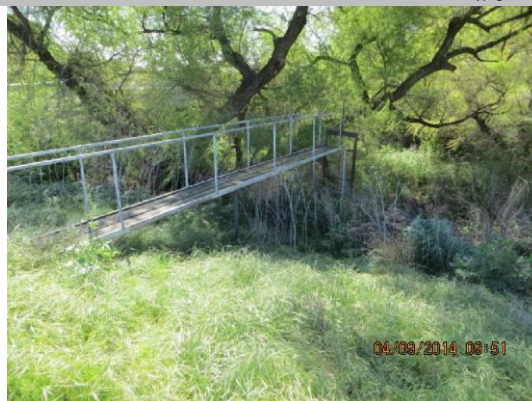
Photo 1 of 3 : UCIP\_SP\_2021\_62666\_60864.jpg

FS\_ID:62666  
DS\_ID:19624  
EP\_NO: 12156  
Repair Type: Urgent  
Crossing Status: Found  
UCIP Comments: 10/20/2020 Dense vegetation prevented a full inspection of this crossing. Crossing remains Urgent due to previously observed signs of pipe being rusted through visible from the WS. Need to contact owner to clear the dense vegetation on both the WS and the LS to be able to perform proper inspection of crossing. (B. Singh - GEI, O. Magana - DWR UCIP)11/01/2018 Dense vegetation prevented a full inspection of this crossing. Assumed crossing remains the same as the 2016 inspection. Crossing remains Urgent due to signs of pipe being rusted through visible from the WS. Need to contact owner to clear the dense vegetation on both the WS and the LS to be able to perform proper inspection of crossing. (O. Magana - DWR UCIP)7/19/2016 same as previous inspection--pipe rusted through. Sediment visible inside LS pipe; walkway wood panels have dry rot and appears to be unsafe to use. (O. Magana - DWR UCIP)4/09/2014 Slide gate rusted through and open on WS toe. Inlet appears to be obscured or covered in soil at LS toe. Also dense vegetation on waterward and landward sides. Need to contact owner to contact CVFPB to address issue. (W. Wylie - DWR UCIP)

FIELD\_STRUCT\_DESC: 26-inch steel pipe sleeved through a 30-inch reinforced concrete gravity drainage pipe through the levee, 7.3 feet below the crown. Annular space grouted between the two pipes. Two concrete cutoff walls in the center of the levee. Slide gate with elevated walkway access on the waterside (WS) end. 6-inch thick concrete headwall on the WS end. Concrete wing walls on each end. (Plans to install a 30-inch storm drainage pipe with a valve through the levee authorized under Permit No. 12156, 1977 - Merquin County Water District). (Additional Related Permit(s): Permit No. 12156-A, 1978 - Merquin County Water District). [Additional Reference(s): DWR Levee Log, 2002 (HLM 9.01), listed as a 30-inch concrete pipe].  
FS Date: 10/20/2020

Metal walkway to slidegate operator on WS toe.

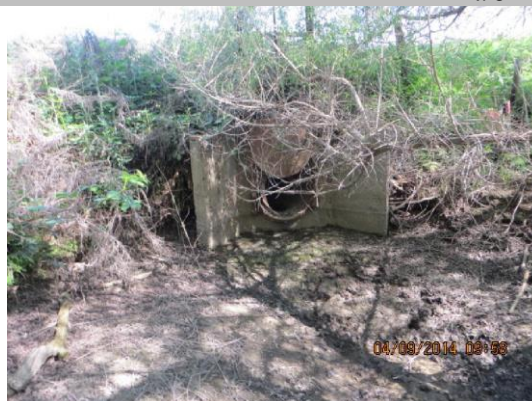
Photo 2 of 3 : UCIP\_SP\_2021\_62666\_60862.jpg

Slidegate and headwall at WS toe.

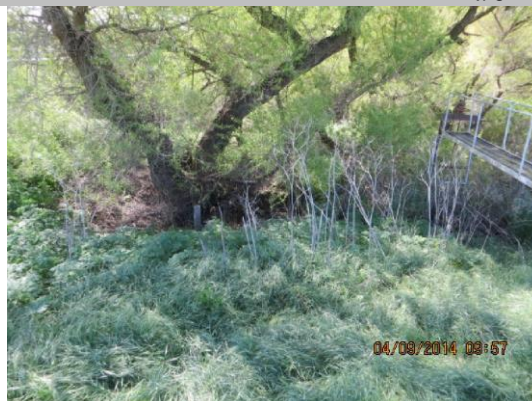
Photo 1 of 3 : UCIP\_SP\_2021\_62665\_60870.jpg

FS\_ID:62665  
DS\_ID:19625  
EP\_NO: N/A  
Repair Type: Non-Urgent  
Crossing Status: Found  
UCIP Comments: 10/20/2020 As in previous inspection, dense vegetation inhibited proper inspection of the pipe and slope. Pipe status is still Non-Urgent. No permit was found authorizing this encroachment. CVFPB will need to review crossing to determine owner. DWR DMP has not completed an internal inspection of the pipe but is scheduled for 2021. (B. Singh - GEI, O. Magana - DWR UCIP)04/09/2014  
Dense vegetation limits the inspector's visibility to identify signs of pipe failure (leaks) along the slope. Recommend removing vegetation along pipe alignment to conduct proper inspection of structure. Some sediment buildup in pipe. (W. Wylie - DWR UCIP)  
FIELD\_STRUCT\_DESC: 36-inch corrugated metal gravity drainage pipe through the levee, 10 feet below the crown. Flap gate on the waterside (WS) end. Brass cap No. 80 bench mark (BM) on the headwall on the landside (LS). [Additional Reference(s): DWR Levee Log, 2002 (HLM 9.01), listed as a 36-inch corrugated metal pipe (CMP). USACE San Joaquin O&M Manual, Unit 601 Part 1 (SJR601.1), 1967, Revised 25 May 2011, (HLM 9.00), listed as a 36-inch CMP].

Pipe and flapgate visible on WS toe.

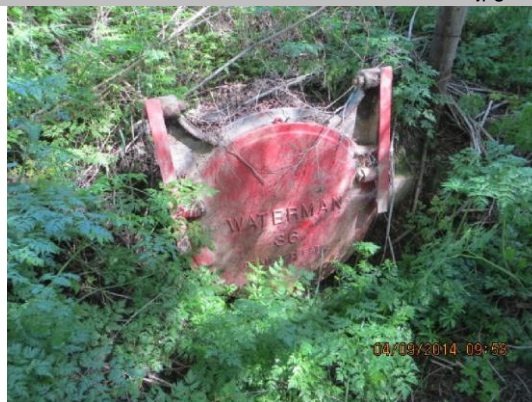
Photo 2 of 3 : UCIP\_SP\_2021\_62665\_60869.jpg

Pipe and flapgate visible on WS toe.

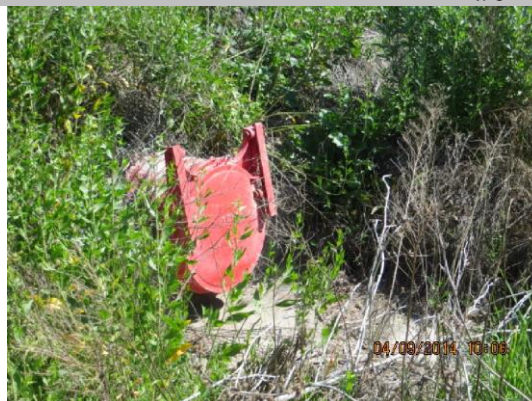
Photo 2 of 3 : UCIP\_SP\_2021\_62695\_60871.jpg

Pipe, concrete headwall, and flapgate at WS toe.

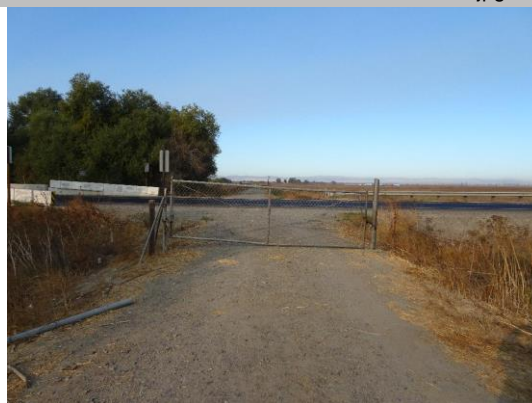
Photo 3 of 3 : UCIP\_SP\_2021\_62695\_90906.jpg

Overview of levee crown

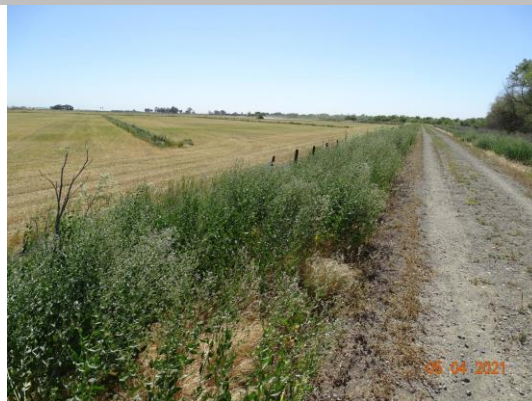
Photo 1 of 1 : SP\_2021\_NA0010\_118\_129\_20210517\_00308.jpg

LM Start	9.01	Rating **	U	Issue No.	129
LM End	9.62	Issue Type +	Ma	Location *	LS
Category	Earthen Levee			GPS Latitude/Longitude	
				Start	End
Item	Vegetation			37.297502 °	37.295038 °
				-120.850732 °	-120.840723 °
DWR ID	DWR_NA0010_01_s_2021_129				
Comment Code					
V1 : Control annual grass and weeds on the levee slopes and easements.					
Inspector Comment

View of the landside slope looking upstream. (Spring 2021)

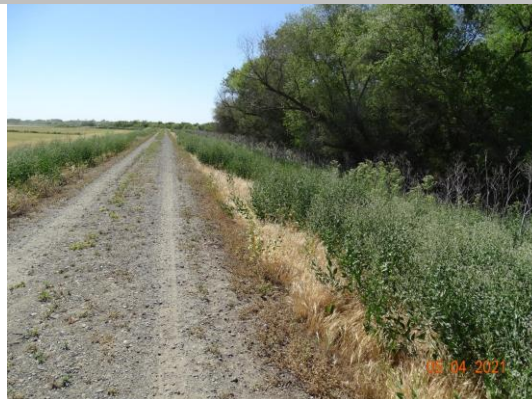
Photo 1 of 1 : SP\_2021\_NA0010\_118\_131\_20210517\_00309.jpg

LM Start	9.01	Rating **	U	Issue No.	131
LM End	9.50	Issue Type +	Ma	Location *	WS
Category	Earthen Levee			GPS Latitude/Longitude	
				Start	End
Item	Vegetation			37.297502 °	37.295457 °
				-120.850731 °	-120.842752 °
DWR ID	DWR_NA0010_01_s_2021_131				
Comment Code					
V1 : Control annual grass and weeds on the levee slopes and easements.					
Inspector Comment

Looking upstream along the waterside slope. (Spring 2021)

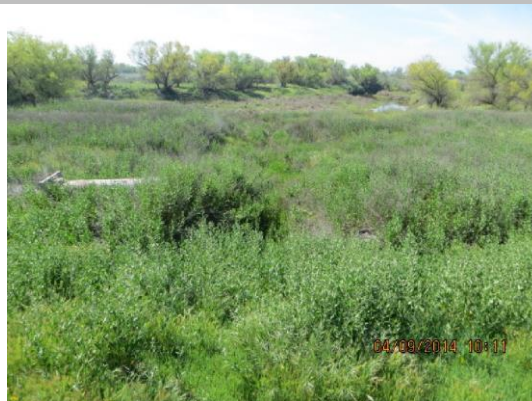
Photo 1 of 3 : UCIP\_SP\_2021\_62696\_60875.jpg

Comment Code						
Inspector Comment						
FS_ID:62696 DS_ID:19627 EP_NO: N/A Repair Type: Urgent Crossing Status: Found UCIP Comments: 10/21/2020 Pipe status is Urgent. DWR DMP has found integrity issues, LOF between 5 and 6. Scouring observed approximately 2 feet DS of pipe at WS toe. Crossing will be monitored until funding becomes available for removal. No permit was found authorizing this encroachment. CVFPB will need to review crossing to determine owner. (B. Singh - GEI, O. Magana - DWR UCIP)04/09/2014 Dense vegetation limits the inspector's visibility to identify signs of pipe failure (leaks) along the slope. Recommend removing vegetation along pipe alignment to conduct proper inspection of structure. (W. Wylie - DWR UCIP ) FIELD_STRUCT_DESC: 24-inch corrugated metal gravity drainage pipe through the levee, 8.6 feet below the crown. Concrete drop inlet at the landside (LS) toe. Flap gate on the waterside (WS) end. Brass cap No. 80 bench mark (BM) on the headwall on the LS. [Additional Reference(s): DWR Levee Log, 2002 (HLM 9.39), listed as a 24-inch corrugated metal pipe (CMP). USACE San Joaquin O&M Manual, Unit 601 Part 1 (SJR601.1), 1967, Revised 25 May 2011, (HLM 9.37), listed as 24-inch CMP]. FS Date: 10/21/2020

Pipe and flapgate on WS toe.

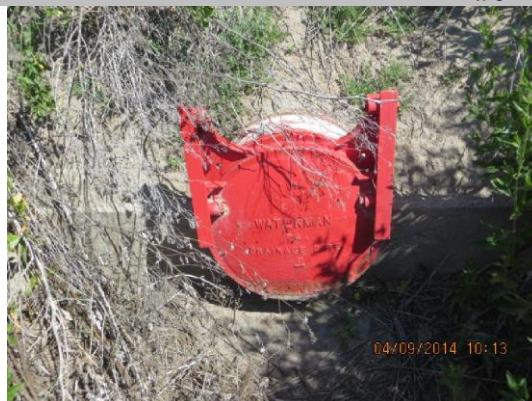
Photo 2 of 3 : UCIP\_SP\_2021\_62696\_60876.jpg

Headwall, Pipe, and flapgate on WS toe.

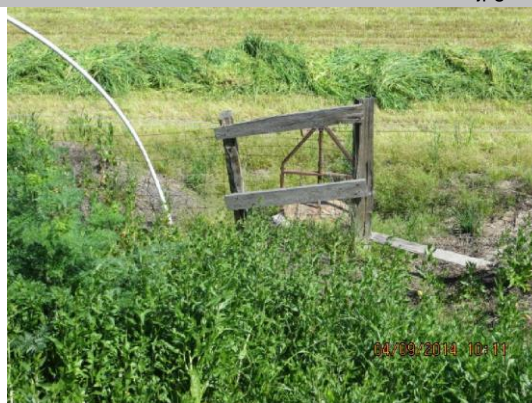
Photo 3 of 3 : UCIP\_SP\_2021\_62696\_60874.jpg

Concrete drop-inlet installed on pipe at LS toe.

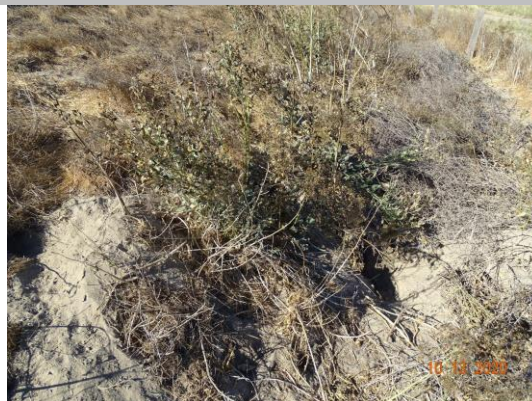
Photo 1 of 1 : SP\_2021\_NA0010\_118\_101\_20210308\_00012.jpg

Rodent burrows in the landside slope. (Fall 2020)

LM Start	9.56	Rating **	M	Issue No.	101
LM End	9.56	Issue Type +	Ma	Location *	LS
Category	Earthen Levee			GPS Latitude/Longitude	
				Start	End
Item	Animal Control			37.295541 °	37.295541 °
				-120.841739 °	-120.841739 °
DWR ID	DWR_NA0010_01_f_2020_101				
Comment Code					
A1 : Exterminate rodents and backfill and compact or grout burrows.					
Inspector Comment

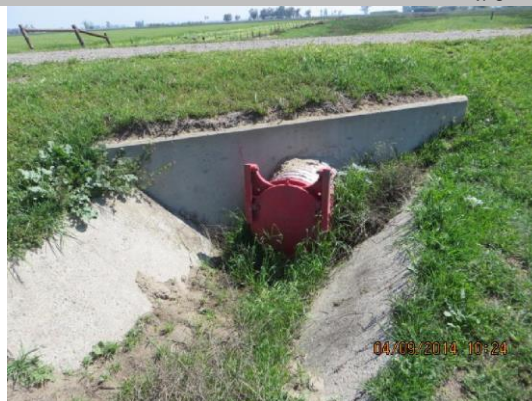
Photo 1 of 3 : UCIP\_SP\_2021\_62697\_60880.jpg

FS\_ID:62697  
DS\_ID:19628  
EP\_NO: N/A  
Repair Type: Non-Urgent  
Crossing Status: Found  
UCIP Comments: 10/21/2020 Pipe status is still Non-Urgent. No permit was found authorizing this encroachment. CVFPB will need to review crossing to determine owner. DWR DMP has not found internal issues, LOF between 1 and 2. Recommend inspection in 5 years. (B. Singh - GEI, O. Magana - DWR UCIP)  
FIELD\_STRUCT\_DESC: 24-inch corrugated metal gravity drainage pipe through the levee, 4.5 feet below the crown. Flap gate on the waterside (WS) end. Brass cap No. 80 bench mark (BM) on the headwall on the landside (LS). [Additional Reference(s): DWR Levee Log, 2002 (HLM 9.68), listed as a 24-inch corrugated metal pipe (CMP). USACE San Joaquin O&M Manual, Unit 601 Part 1 (SJR601.1), 1967, Revised 25 May 2011, (HLM 9.67), listed as a 24-inch CMP].  
FS Date: 10/21/2020

Pipe, flapgate, and headwall visible on WS toe.

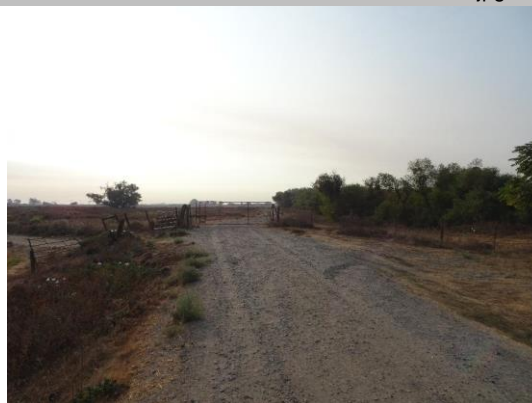
Photo 2 of 3 : UCIP\_SP\_2021\_62697\_90915.jpg

Overview of levee crown

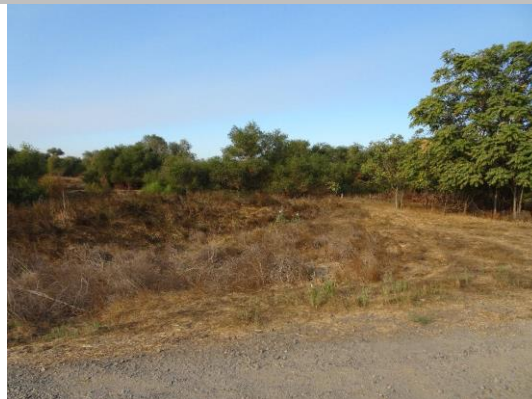
Photo 3 of 3 : UCIP\_SP\_2021\_62697\_90916.jpg

View waterward

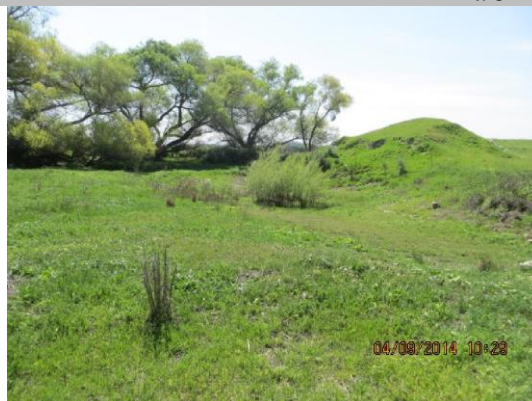
Photo 1 of 3 : UCIP\_SP\_2021\_62746\_60882.jpg

FS\_ID:62746  
 DS\_ID:19976  
 EP\_NO: N/A  
 Repair Type: Non-Urgent  
 Crossing Status: Not Found  
 UCIP Comments: 10/21/2020 Pipes removed and replaced with two culverts at grade. No permit was found authorizing this encroachment. CVFPB will need to review crossing to determine owner. 04/09/2014 Appears to have been washed out at levee breach. (W. Wylie - DWR UCIP)  
 FIELD\_STRUCT\_DESC: 24-inch corrugated metal gravity drainage pipe through the levee, at an unknown depth. Cross fence with metal drive gate on the levee crown. Access on the waterside (WS).  
 FS Date: 10/21/2020

Area of levee breach.

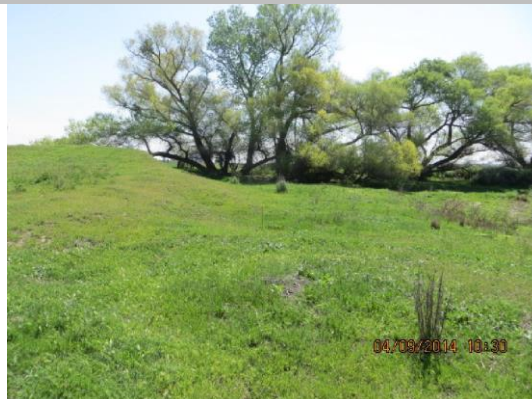
Photo 2 of 3 : UCIP\_SP\_2021\_62746\_60881.jpg

Area of levee breach.

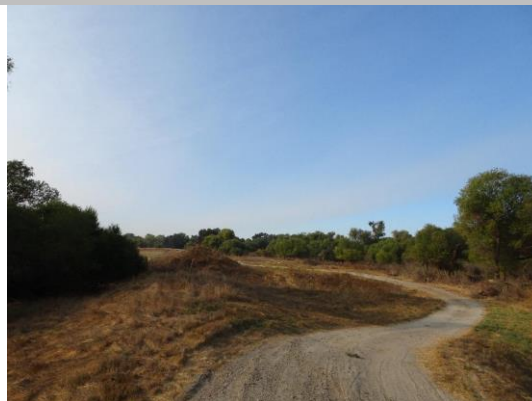
Photo 3 of 3 : UCIP\_SP\_2021\_62746\_91039.jpg

Overview of area

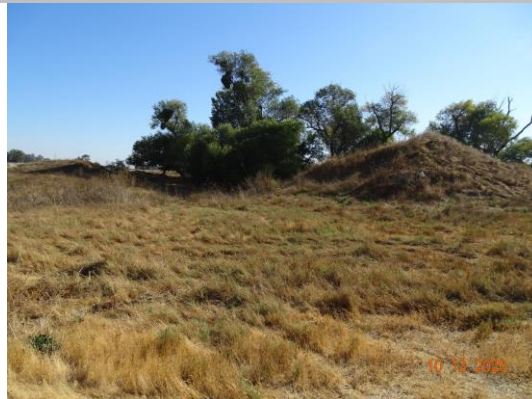
Photo 1 of 1 : SP\_2021\_NA0010\_118\_112\_20210308\_00019.jpg

LM Start	9.89	Rating **	A/W	Issue No.	112
LM End	9.90	Issue Type +	Ma	Location *	CR
Category	Earthen Levee			GPS Latitude/Longitude	
				Start	End
Item	Erosion / Bank Caving			37.291796 °	37.291581 °
				-120.839497 °	-120.839718 °
DWR ID	DWR_NA0010_01_f_2017_112				
Comment Code					
E1 : Note and monitor erosion site.					
Inspector Comment					
Landowner degraded levee in the 1970's because water on LS was flooding his property. Landowner has prevented efforts to restore levee. LMA has stated that no water from the waterside of the levee has ever backed up through the degraded levee and caused flooding.

Looking east at the levee breach. (Fall 2020)

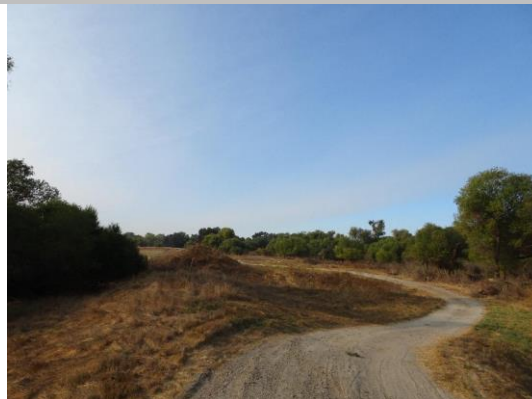
Photo 1 of 3 : UCIP\_SP\_2021\_62747\_91045.jpg

FS\_ID:62747  
DS\_ID:19556  
EP\_NO: N/A  
Repair Type: Non-Urgent  
Crossing Status: Not Found  
UCIP Comments: 10/21/2020 Pipe removed and replaced with two culverts at grade. No permit was found authorizing this encroachment. CVFPB will need to review crossing to determine owner. (B. Singh - GEI, O. Magana - DWR UCIP)  
FIELD\_STRUCT\_DESC: 24-inch corrugated metal gravity drainage pipe through the levee, 6 feet below the crown. Flap gate on the waterside (WS) end. Brass cap No. 70 bench mark (BM) on the headwall on the landside (LS). [Additional Reference(s): DWR Levee Log, 2002 (HLM 9.91), listed as a 24-inch corrugated metal pipe (CMP). USACE San Joaquin O&M Manual, Unit 601 Part 1 (SJR601.1), 1967, Revised 25 May 2011, (HLM 9.93), listed as a 24-inch CMP].  
FS Date: 10/21/2020

Overview of area

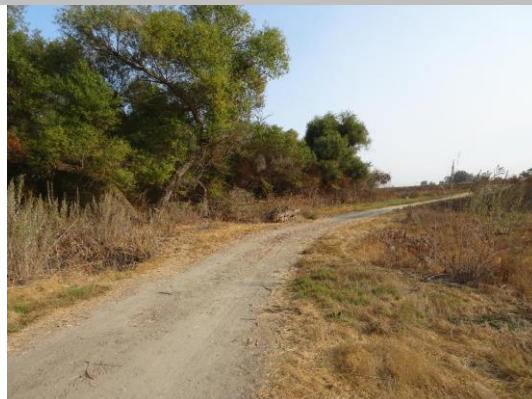
Photo 2 of 3 : UCIP\_SP\_2021\_62747\_91046.jpg

Overview of levee crown at crossing

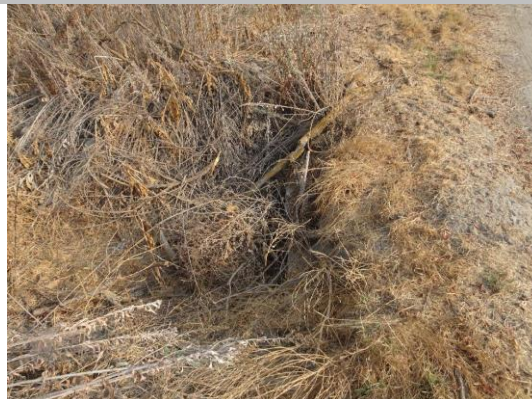
Photo 3 of 3 : UCIP\_SP\_2021\_62747\_91047.jpg

Culverts at WS toe

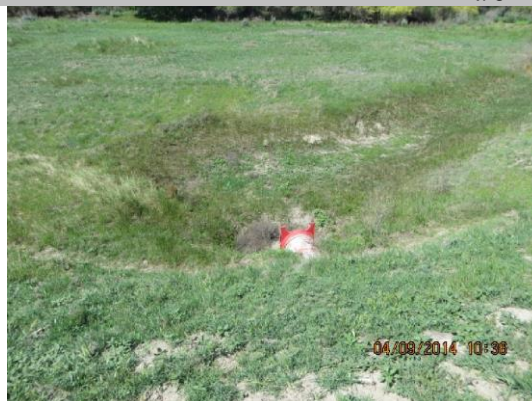
Photo 1 of 3 : UCIP\_SP\_2021\_62698\_60884.jpg

FS\_ID:62698  
DS\_ID:19629  
EP\_NO: N/A  
Repair Type: Non-Urgent  
Crossing Status: Found  
UCIP Comments: 10/21/2020 Pipe status is still Non-Urgent. No permit was found authorizing this encroachment. CVFPB will need to review crossing to determine owner. DWR DMP has not found internal issues, LOF between 1 and 2. Recommend inspection in 5 years. (B. Singh - GEI, O. Magana - DWR UCIP)04/09/2014 Dense vegetation blocks waterward and landward toes Recommend removing vegetation from both toes. Also sediment buildup in pipe visible from landward side. (W. Wylie - UCIP DMP)  
FIELD\_STRUCT\_DESC: 24-inch corrugated metal gravity drainage pipe through the levee, 9 feet below the crown. Flap gate on the waterside (WS) end. Brass cap No. 69 bench mark (BM) on the headwall on the landside (LS). [Additional Reference(s): DWR Levee Log, 2002 (HLM 10.24), listed as a 24-inch corrugated metal pipe (CMP). USACE San Joaquin O&M Manual, Unit 601 Part 1 (SJR601.1), 1967, Revised 25 May 2011, (HLM 10.23), listed as a 24-inch CMP].

Pipe, headwall, and flapgate on WS toe.

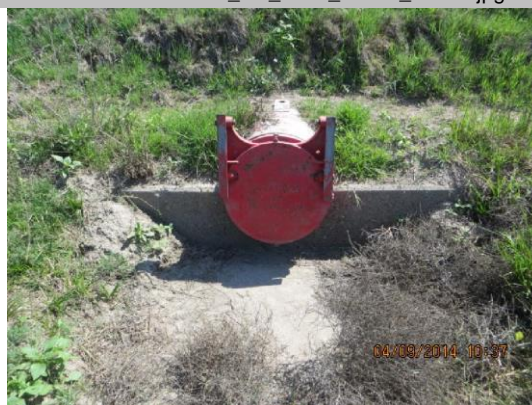
Photo 2 of 3 : UCIP\_SP\_2021\_62698\_60886.jpg

Pipe, headwall, and flapgate at WS toe.

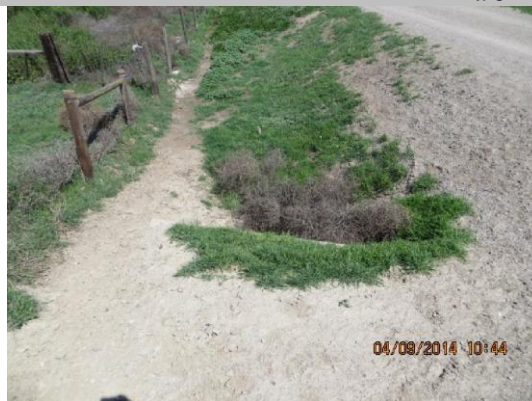
Photo 2 of 3 : UCIP\_SP\_2021\_62711\_60889.jpg

Pipe and headwall on LS toe.

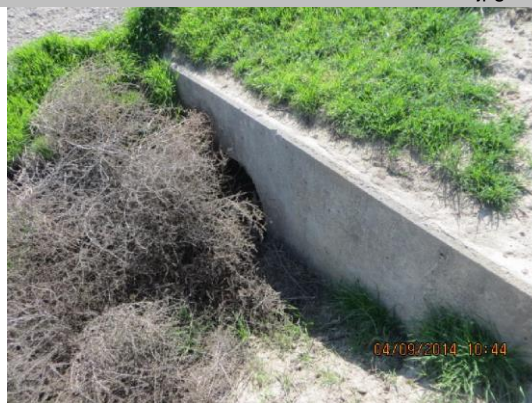
Photo 3 of 3 : UCIP\_SP\_2021\_62711\_60888.jpg

Pipe and headwall on LS toe.
