# Flood Control Project Maintenance Levee Inspections LMA District Cover Sheet

## Lower San Joaquin Levee District

**Flood Control Project Maintenance  
Levee Inspections  
Unit Cover Sheet**

Waterway			Bank	Unit Miles
Unit No. 01 San Joaquin River			Right	22.52
	Spring (March - May)	Summer (June - August)	(September - November) Fall	Winter (December - February)
Unit Maintenance Rating (Fall Only)				
Date of Inspection	5/4/2021 - 5/4/2021			
DWR Inspector	Corey Fujitani			
Accompanied By

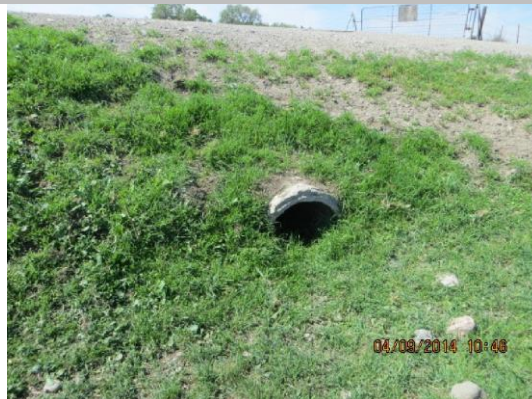
Photo 3 of 3 : UCIP\_SP\_2021\_62714\_60895.jpg

Concrete pipe visible on LS slope.

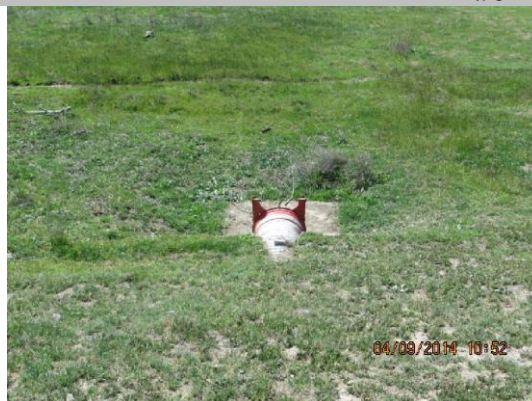
Photo 1 of 3 : UCIP\_SP\_2021\_62699\_60897.jpg

FS\_ID:62699  
DS\_ID:19632  
EP\_NO: N/A  
Repair Type: Non-Urgent  
Crossing Status: Found  
UCIP Comments: 10/21/2020 Pipe status is still Non-Urgent. No permit was found authorizing this encroachment. CVFPB will need to review crossing to determine owner. DWR DMP has not found internal issues, LOF between 1 and 2. Recommend inspection in 5 years. (B. Singh - GEI, O. Magana - DWR UCIP)04/09/2014 Dense vegetation blocks landward headwall. Recommend removing excess vegetation on landward toe. (W. Wylie - DWR UCIP)  
FIELD\_STRUCT\_DESC: 24-inch corrugated metal gravity drainage pipe through the levee, 6 feet below the crown. Flap gate on the waterside (WS) end. Brass cap No. 66 bench mark (BM) on the headwall on the landside (LS). [Additional Reference(s): DWR Levee Log, 2002 (HLM 11.02), listed as a 24-inch corrugated metal pipe (CMP). USACE San Joaquin O&M Manual, Unit 601 Part 1 (SJR601.1), 1967, Revised 25 May 2011, (HLM 11.00), listed as a 24-inch CMP].

Pipe, headwall, and flapgate on WS toe.

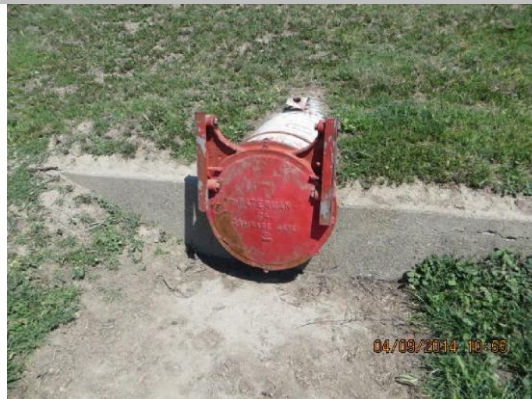
Photo 2 of 3 : UCIP\_SP\_2021\_62699\_60899.jpg

Pipe, headwall, and flapgate on WS toe.

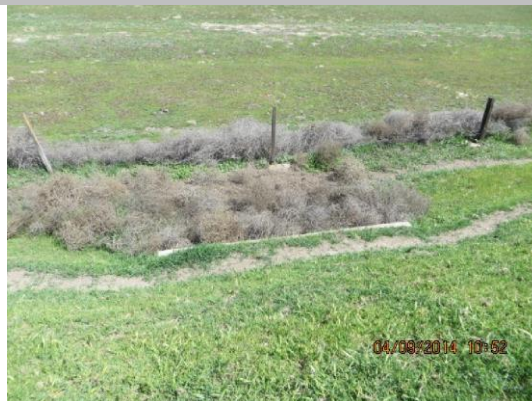
Photo 3 of 3 : UCIP\_SP\_2021\_62699\_60898.jpg

Pipe and headwall on LS toe.

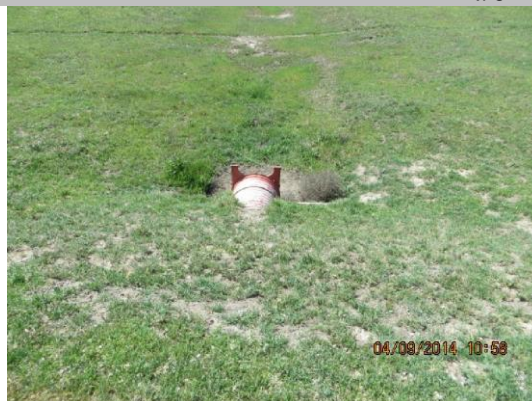
Photo 1 of 3 : UCIP\_SP\_2021\_62700\_60903.jpg

FS\_ID:62700  
DS\_ID:19633  
EP\_NO: N/A  
Repair Type: Non-Urgent  
Crossing Status: Found  
UCIP Comments: 10/21/2020 Pipe status is still Non-Urgent. No permit was found authorizing this encroachment. CVFPB will need to review crossing to determine owner. DWR DMP has not found internal issues, LOF between 1 and 2. Recommend inspection in 5 years. (B. Singh - GEI, O. Magana - DWR UCIP)  
FIELD\_STRUCT\_DESC: 24-inch corrugated metal gravity drainage pipe through the levee, 5 feet below the crown. Flap gate on the waterside (WS) end. Brass cap No. 65 bench mark (BM) on the headwall on the landside (LS). [Additional Reference(s): DWR Levee Log, 2002 (HLM 11.20), listed as a 24-inch corrugated metal pipe (CMP). USACE San Joaquin O&M Manual, Unit 601 Part 1 (SJR601.1), 1967, Revised 25 May 2011, (HLM 11.18), listed as a 24-inch CMP].  
FS Date: 10/21/2020

Pipe, headwall, and flapgate on WS toe.

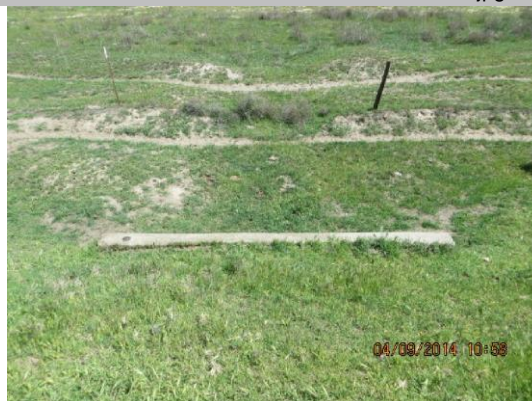
Photo 2 of 3 : UCIP\_SP\_2021\_62700\_60902.jpg

Pipe and headwall at LS toe.

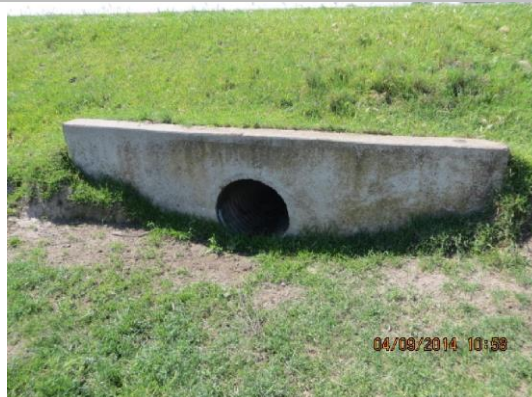
Photo 3 of 3 : UCIP\_SP\_2021\_62700\_60901.jpg

Pipe and headwall at LS toe.

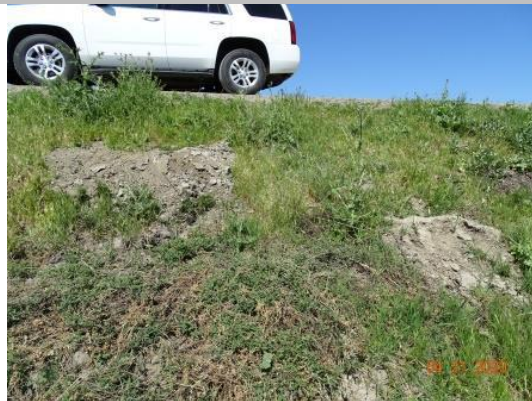
Photo 1 of 1 : SP\_2021\_NA0010\_118\_151\_20210308\_00030.jpg

Rodent burrows in the landside slope. (Spring 2020)

LM Start	11.37	Rating **	M	Issue No.	151
LM End	11.37	Issue Type +	Ma	Location *	LS
Category	Earthen Levee			GPS Latitude/Longitude	
				Start	End
Item	Animal Control			37.275481 °	37.275481 °
				-120.826042 °	-120.826042 °
DWR ID	DWR_NA0010_01_s_2020_151				
Comment Code					
A1 : Exterminate rodents and backfill and compact or grout burrows.					
Inspector Comment

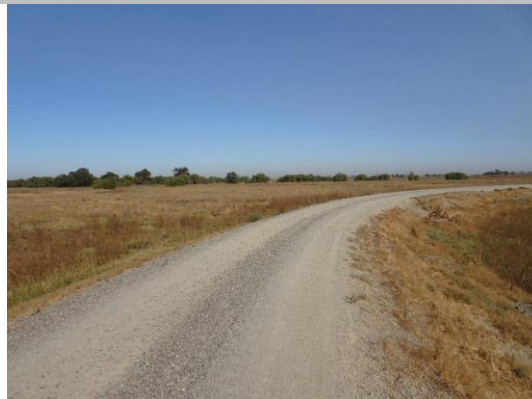
Photo 1 of 3 : UCIP\_SP\_2021\_62701\_90940.jpg

FS\_ID:62701  
DS\_ID:19814  
EP\_NO: N/A  
Repair Type: Non-Urgent  
Crossing Status: Found  
UCIP Comments: 10/21/2020 Pipe status is still Non-Urgent. Steep slopes prevented further inspection. No permit was found authorizing this encroachment. CVFPB will need to review crossing to determine owner. DWR DMP has not found internal issues, LOF between 1 and 2. Recommend inspection in 5 years. (B. Singh - GEI, O. Magana - DWR UCIP)  
FIELD\_STRUCT\_DESC: 24-inch corrugated metal gravity drainage pipe through levee, 12 feet below the crown. Two metal cutoff walls. Flap gate on the waterside (WS) end. Concrete headwall on the landside (LS) end. Concrete saddle and apron on the WS end.  
[Additional Reference(s): DWR Levee Log, 2002. USACE San Joaquin O&M Manual 601.1, 1967, (recorded as U6 HLM 0.05 should be U1 HLM 11.37)].  
FS Date: 10/21/2020

Overview of levee crown

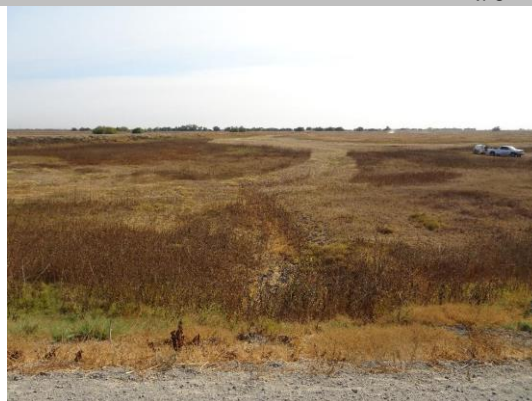
Photo 2 of 3 : UCIP\_SP\_2021\_62701\_90941.jpg

View landward

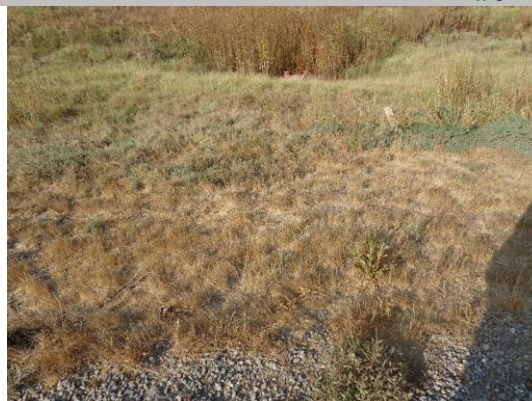
Photo 3 of 3 : UCIP\_SP\_2021\_62701\_90942.jpg

View waterward. Pipe and flapgate visible

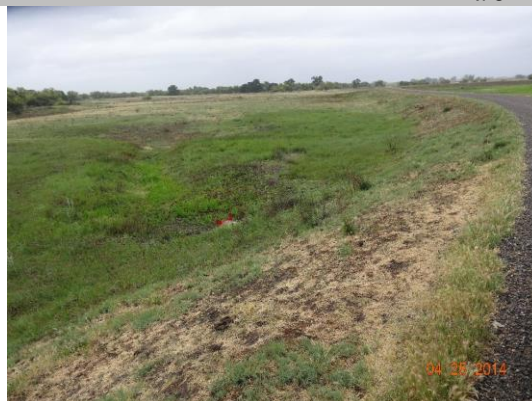
Photo 1 of 3 : UCIP\_SP\_2021\_62702\_65362.jpg

FS\_ID:62702  
DS\_ID:19634  
EP\_NO: N/A  
Repair Type: Urgent  
Crossing Status: Found  
UCIP Comments: 10/21/2020 Pipe status is Urgent. DWR DMP has found integrity issues, LOF between 4 and 5. Dense vegetation inhibited inspection of pipe and headwall at LS toe; Pipe not found at LS toe. Crossing will be monitored until funding becomes available for rehabilitation. No permit was found authorizing this encroachment. CVFPB will need to review crossing to determine owner. (B. Singh - GEI, O. Magana - DWR UCIP)04/25/2014 Need to contact owner--landward side has been buried. It appears that soil was removed from levee toe, immediately upstream, and used to pile soil at landward side at crossing. (O. Magana - DWR UCIP)  
FIELD\_STRUCT\_DESC: 24-inch corrugated metal gravity drainage pipe through the levee, 10 feet below the crown. Flap gate on the waterside (WS) end. Brass cap No. 62 bench mark (BM) on the headwall on the landside (LS). [Additional Reference(s): DWR Levee Log, 2002 (HLM 11.48), listed as a 24-inch corrugated metal pipe (CMP). USACE San Joaquin O&M Manual, Unit 601 Part 1 (SJR601.1), 1967, Revised 25 May 2011, (HLM 11.48), listed as a 24-inch CMP].

View of waterward side.

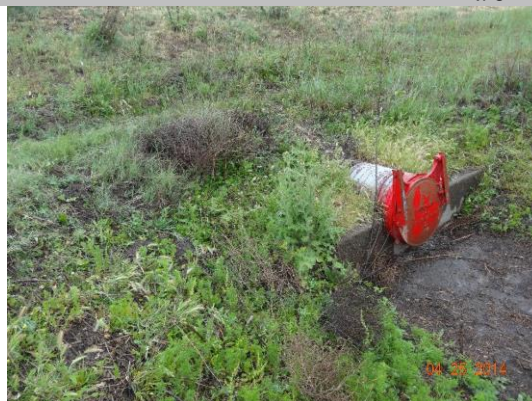
Photo 2 of 3 : UCIP\_SP\_2021\_62702\_65364.jpg

View of concrete headwall and flap gate visible on waterward side.

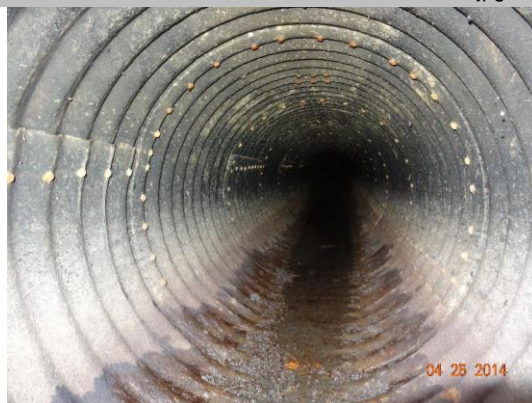
Photo 3 of 3 : UCIP\_SP\_2021\_62702\_65363.jpg

Inside view of pipe from waterward side.

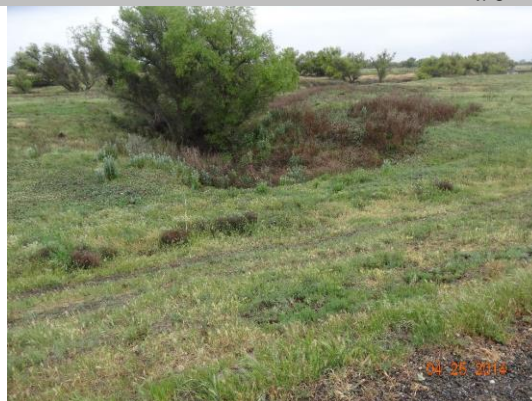
Photo 1 of 3 : UCIP\_SP\_2021\_62703\_65372.jpg

Comment Code						
Inspector Comment						
FS_ID:62703 DS_ID:19635 EP_NO: N/A Repair Type: Non-Urgent Crossing Status: Found UCIP Comments: 10/21/2020 Pipe status is still Non-Urgent. Geophysics study found evidence of pipe at coordinates 2272708.537, 13540017.857. Pipe and flapgate buried by dry vegetation at WS toe and pipe and headwall blocked by debris at LS toe, inhibiting proper inspection. Recommend removal of excess vegetation. No permit was found authorizing this encroachment. CVFPB will need to review crossing to determine owner. DWR DMP has not completed an internal inspection of the pipe but is scheduled for 2021. (B. Singh - GEI, O. Magana - DWR UCIP)04/25/2014 Crossing is non-functional -- landward side is buried. Debris found on landward side (channel). Dense vegetation found on waterward slope. Recommend contacting owner to determine status of crossing. If crossing is no longer used need to coordinate with CVFPB for proper abandonment. (O. Magana - DWR UCIP) FIELD_STRUCT_DESC: 24-inch corrugated metal gravity drainage pipe through the levee, 17 feet below the crown. Flap gate on the waterside (WS) end. Brass cap No. 61 bench mark (BM) on the headwall on the landside (LS). [Additional Reference(s): DWR Levee Log, 2002 (HLM 11.77), listed as a 24-inch corrugated metal pipe (CMP). USACE San Joaquin O&M Manual, Unit 601 Part 1 (SJR601.1), 1967, Revised 25 May 2011, (HLM 11.76), listed as a 24-inch CMP]. FS Date: 10/21/2020

View of waterward side.

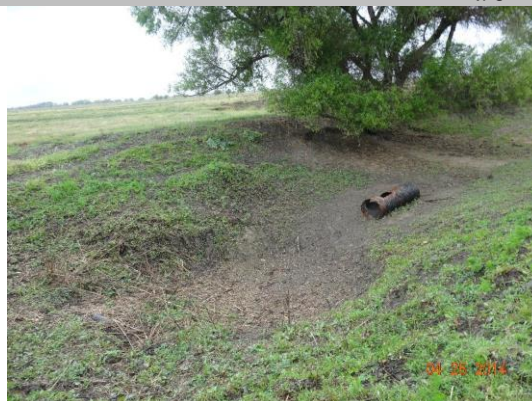
Photo 2 of 3 : UCIP\_SP\_2021\_62703\_65371.jpg

Landward side of crossing buried--damage pipe section visible on landward side.

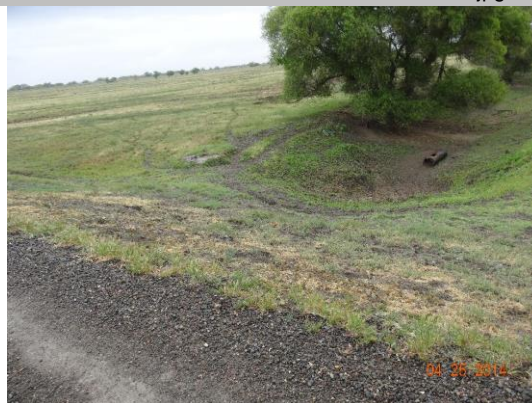
Photo 3 of 3 : UCIP\_SP\_2021\_62703\_65373.jpg

View of landward side.

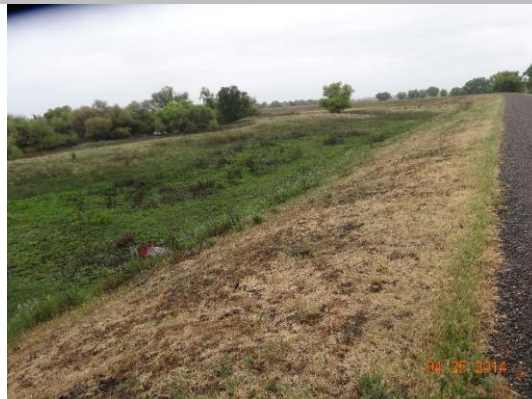
Photo 1 of 3 : UCIP\_SP\_2021\_62704\_65378.jpg

FS\_ID:62704  
DS\_ID:19636  
EP\_NO: N/A  
Repair Type: Non-Urgent  
Crossing Status: Found  
UCIP Comments: 10/21/2020 Dense vegetation inhibited proper inspection of pipe at LS and WS toes. Pipe status is still Non-Urgent. No permit was found authorizing this encroachment. CVFPB will need to review crossing to determine owner. DWR DMP has not completed an internal inspection of the pipe but is scheduled for 2021. (B. Singh - GEI, O. Magana - DWR UCIP)04/25/2014 Crossing is non-functional --landward side is buried. Dense vegetation found on waterward slope. Recommend contacting owner to determine status of crossing. If crossing is no longer used need to coordinate with CVFPB for proper abandonment. (O. Magana - DWR UCIP)  
FIELD\_STRUCT\_DESC: 24-inch corrugated metal gravity drainage pipe through the levee, 12.4 feet below the crown. Flap gate on the waterside (WS) end. Brass cap No. 60 bench mark (BM) on the headwall on the landside (LS). [Additional Reference(s): DWR Levee Log, 2002 (HLM 12.12), listed as a 24-inch corrugated metal pipe (CMP). USACE San Joaquin O&M Manual, Unit 601 Part 1 (SJR601.1), 1967, Revised 25 May 2011, (HLM 12.11), listed as a 24-inch CMP].

View of waterward side--flap gate visible on waterward toe.

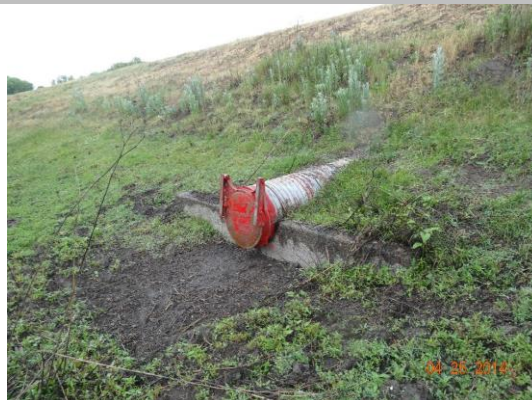
Photo 2 of 3 : UCIP\_SP\_2021\_62704\_65379.jpg

Flap gate and concrete headwall visible on waterward side.

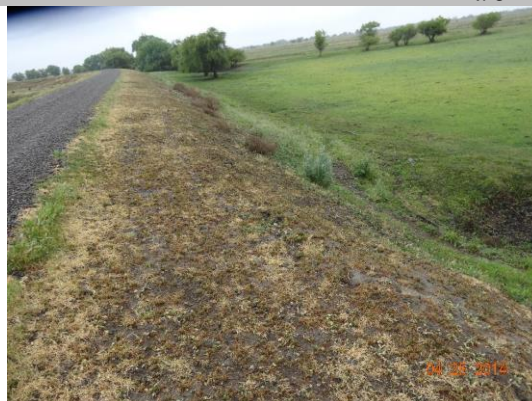
Photo 3 of 3 : UCIP\_SP\_2021\_62704\_65377.jpg

View of landward side.

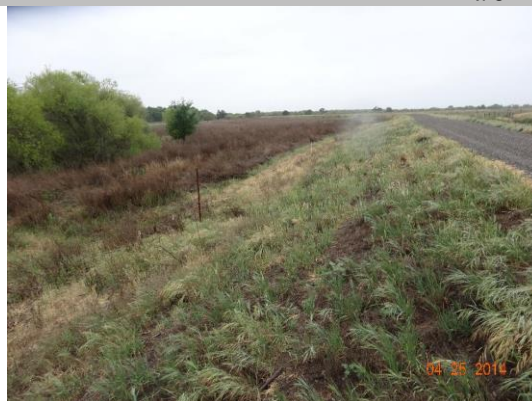
Photo 1 of 3 : UCIP\_SP\_2021\_62705\_65412.jpg

FS\_ID:62705  
DS\_ID:19637  
EP\_NO: N/A  
Repair Type: Urgent  
Crossing Status: Found  
UCIP Comments: 10/21/2020 Pipe status is still Urgent. DWR DMP has found integrity issues, LOF between 4 and 5. Crossing will be monitored until funding becomes available for rehabilitation. Proper inspection inhibited by dense vegetation. Recommend vegetation removal. No permit was found authorizing this encroachment. CVFPB will need to review crossing to determine owner. (B. Singh - GEI, O. Magana - DWR UCIP)04/25/2014 Concrete headwall on landward side blocked by debris. Dense vegetation limits the inspector's visibility to identify signs of pipe failure (leaks) along the landward slope. Recommend removing vegetation along pipe alignment to conduct proper inspection of crossing. (O. Magana - DWR UCIP)  
FIELD\_STRUCT\_DESC: 24-inch corrugated metal gravity drainage pipe through the levee, 9.5 feet below the crown. Flap gate on the waterside (WS) end. Brass cap No. 60 bench mark (BM) on the headwall on the landside (LS). [Additional Reference(s): DWR Levee Log, 2002 (HLM 12.95), listed as a 24-inch corrugated metal pipe (CMP). USACE San Joaquin O&M Manual, Unit 601 Part 1 (SJR601.1), 1967, Revised 25 May 2011, (HLM 12.94), listed as a 24-inch CMP].

View of waterward side.

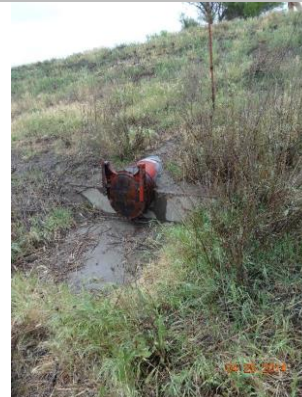
Photo 2 of 3 : UCIP\_SP\_2021\_62705\_65411.jpg

Flap gate and concrete headwall visible on waterward side.

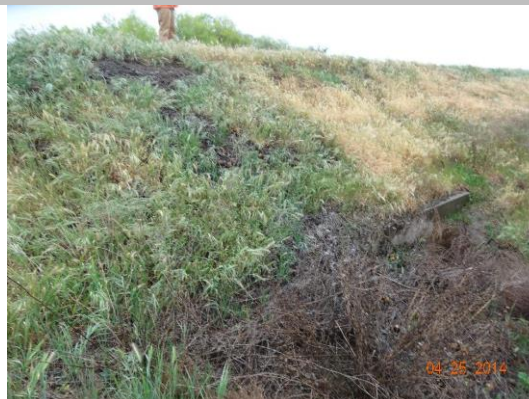
Photo 3 of 3 : UCIP\_SP\_2021\_62705\_65410.jpg

View of landward side--concrete headwall visible covered by dense vegetation.

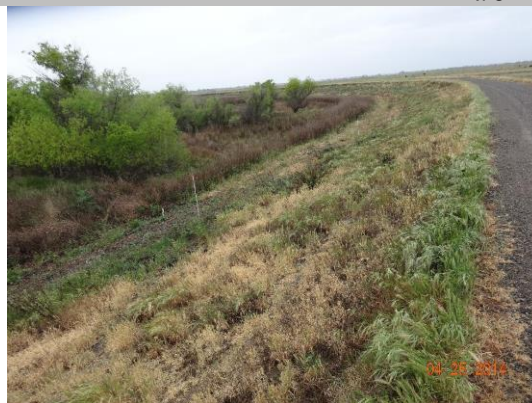
Photo 1 of 3 : UCIP\_SP\_2021\_62706\_65389.jpg

Comment Code					
Inspector Comment					
FS_ID:62706 DS_ID:19638 EP_NO: N/A Repair Type: Non-Urgent Crossing Status: Found UCIP Comments: 10/21/2020 Pipe status is still Non-Urgent. No permit was found authorizing this encroachment. CVFPB will need to review crossing to determine owner. DWR DMP has not completed an internal inspection of the pipe but is scheduled for 2021. (B. Singh - GEI, O. Magana - DWR UCIP)04/25/2014 Dense vegetation limits the inspector's visibility to identify signs of pipe failure (leaks) along the landward slope. Concrete headwall blocked by debris located on landward toe. Recommend clearing debris from landward slope and toe. (O. Magana - DWR UCIP) FIELD_STRUCT_DESC: 24-inch corrugated metal gravity drainage pipe through the levee, 14.2 feet below the crown. Flap gate on the waterside (WS) end. Brass cap No. 60 bench mark (BM) on the headwall on the landside (LS). [Additional Reference(s): DWR Levee Log, 2002 (HLM 13.48), listed as a 24-inch corrugated metal pipe (CMP). USACE San Joaquin O&M Manual, Unit 601 Part 1 (SJR601.1), 1967, Revised 25 May 2011, (HLM 13.48), listed as a 24-inch CMP]. FS Date: 10/21/2020

View of waterward side.

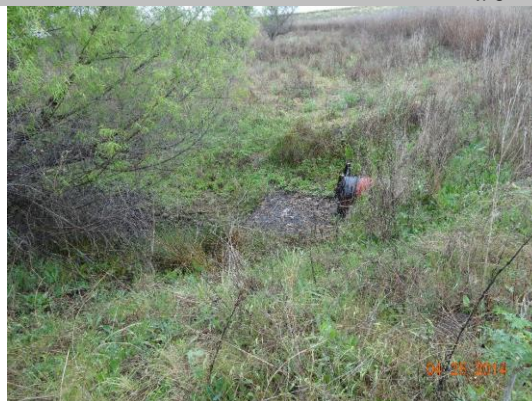
Photo 2 of 3 : UCIP\_SP\_2021\_62706\_65387.jpg

View of flap gate and pipe through levee on waterward side.

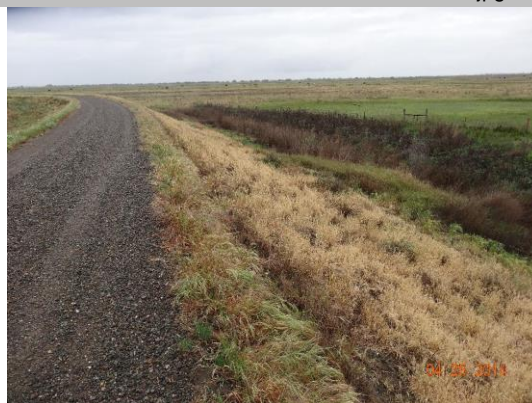
Photo 3 of 3 : UCIP\_SP\_2021\_62706\_65388.jpg

View of landward side.

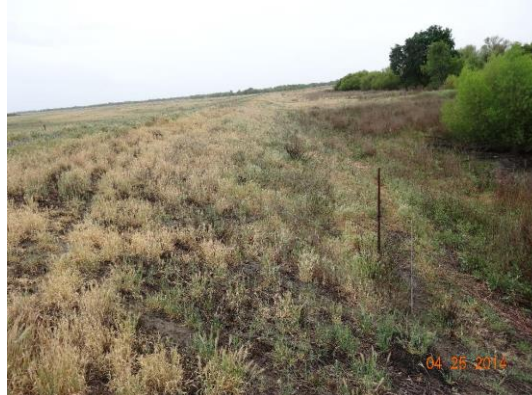
Photo 1 of 3 : UCIP\_SP\_2021\_62707\_65418.jpg

FS\_ID:62707  
DS\_ID:19639  
EP\_NO: N/A  
Repair Type: Non-Urgent  
Crossing Status: Found  
UCIP Comments: 10/21/2020 Pipe status is still Non-Urgent. No permit was found authorizing this encroachment. CVFPB will need to review crossing to determine owner. DWR DMP has not completed an internal inspection of the pipe but is scheduled for 2021. (B. Singh - GEI, O. Magana - DWR UCIP)04/25/2014 No access to waterward toe due to fence. Unable to find the concrete headwall and flap gate on waterward side past fence. Also dense vegetation limits the inspector's visibility to identify signs of pipe failure (leaks) along the waterward slope. Recommend removing vegetation along pipe alignment to conduct proper inspection of structure. Also need access past fence on waterward side. (O. Magana - DWR UCIP)  
FIELD\_STRUCT\_DESC: 24-inch corrugated metal gravity drainage pipe through the levee, 14.5 feet below the crown. Flap gate on the waterside (WS) end. Brass cap No. 60 bench mark (BM) on the headwall on the landside (LS). [Additional Reference(s): DWR Levee Log, 2002 (HLM 13.58), listed as a 24-inch corrugated metal pipe (CMP). USACE San Joaquin O&M Manual, Unit 601 Part 1 (SJR601.1), 1967, Revised 25 May 2011, (HLM 13.58), listed as a 24-inch CMP].

View of waterward side.

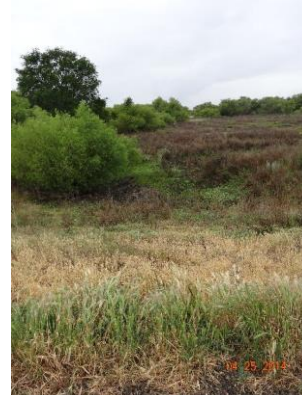
Photo 2 of 3 : UCIP\_SP\_2021\_62707\_65417.jpg

Dense vegetation on waterward side.

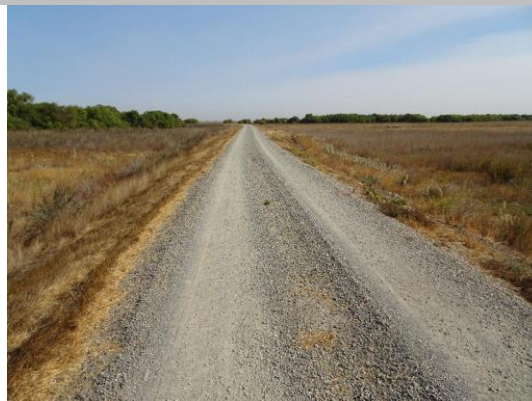
Photo 3 of 3 : UCIP\_SP\_2021\_62708\_90977.jpg

Overview of levee crown

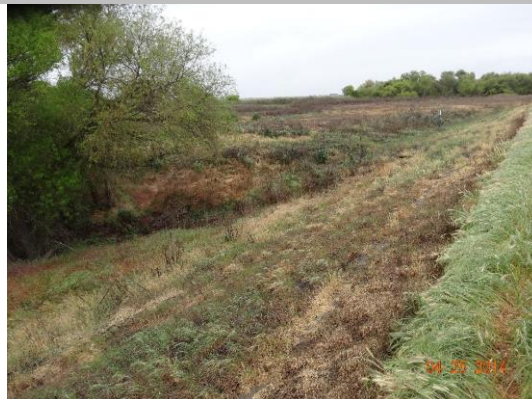
Photo 1 of 3 : UCIP\_SP\_2021\_62709\_65449.jpg

FS\_ID:62709  
DS\_ID:19641  
EP\_NO: N/A  
Repair Type: Non-Urgent  
Crossing Status: Found  
UCIP Comments: 10/21/2020 Dense vegetation at LS and WS toes inhibited proper inspection. Pipe status is still Non-Urgent. No permit was found authorizing this encroachment. CVFPB will need to review crossing to determine owner. DWR DMP has not found internal issues, LOF between 1 and 2. Recommend inspection in 5 years. (B. Singh - GEI, O. Magana - DWR UCIP)04/25/2014 Dense vegetation limits the inspector's visibility to identify signs of pipe failure (leaks) along the slopes. Recommend removing vegetation along pipe alignment to conduct proper inspection of structure. (O. Magana - DWR UCIP)  
FIELD\_STRUCT\_DESC: 24-inch corrugated metal gravity drainage pipe through the levee, 13 feet below the crown. Flap gate on the waterside (WS) end. Brass cap No. 60 bench mark (BM) on the headwall on the landside (LS). [Additional Reference(s): DWR Levee Log, 2002 (HLM 14.22), listed as a 24-inch corrugated metal pipe (CMP). USACE San Joaquin O&M Manual, Unit 601 Part 1 (SJR601.1), 1967, Revised 25 May 2011, (HLM 14.21), listed as a 24-inch CMP].

View of waterward side.

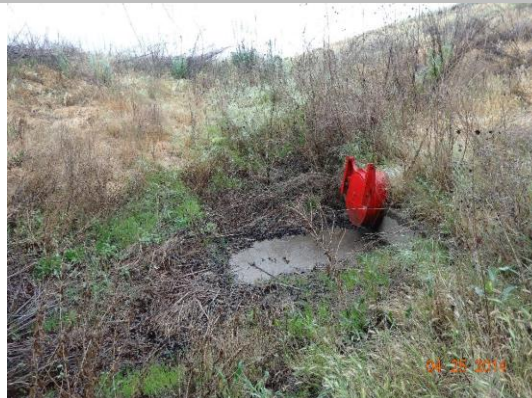
Photo 2 of 3 : UCIP\_SP\_2021\_62709\_65452.jpg

View of concrete headwall, concrete apron, and flap gate on waterward side.

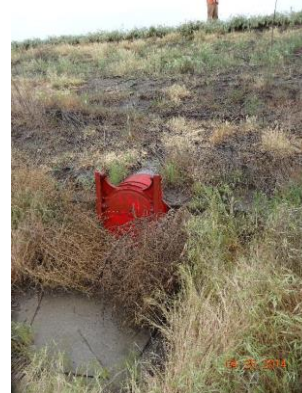
Photo 2 of 3 : UCIP\_SP\_2021\_62710\_65454.jpg

Flap gate, concrete headwall, and concrete apron located on waterward toe.

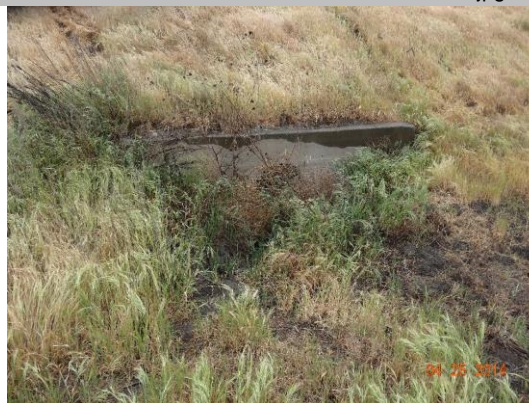
Photo 3 of 3 : UCIP\_SP\_2021\_62710\_65453.jpg

Concrete headwall located on landward toe.

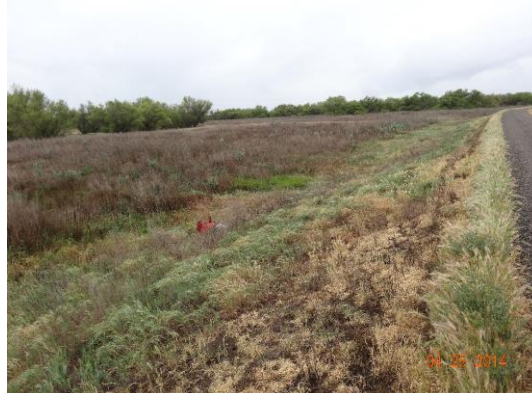
Photo 1 of 3 : UCIP\_SP\_2021\_62672\_65459.jpg

FS\_ID:62672  
DS\_ID:19643  
EP\_NO: N/A  
Repair Type: Non-Urgent  
Crossing Status: Found  
UCIP Comments: 11/16/2020 Pipe status is still Non-Urgent. Dense vegetation on LS toe limiting inhibited inspection of pipe. Significant burrowing observed on LS and WS slopes. Recommend vegetation removal and rodent mitigation. No permit was found authorizing this encroachment. CVFPB will need to review crossing to determine owner. DWR DMP has not found internal issues, LOF between 1 and 2. Recommend inspection in 5 years. (B. Singh - GEI, O. Magana - DWR UCIP)04/25/2014 Dense vegetation limits the inspector's visibility to identify signs of pipe failure (leaks) along the landward slope. Recommend removing vegetation along pipe alignment to conduct proper inspection of structure. (O. Magana - DWR UCIP)  
FIELD\_STRUCT\_DESC: 24-inch corrugated metal gravity drainage pipe through the levee, 9.2 feet below the crown. Flap gate on the waterside (WS) end. Brass cap No. 60 bench mark (BM) on the headwall on the landside (LS). [Additional Reference(s): DWR Levee Log, 2002 (HLM 15.31), listed as a 24-inch corrugated metal pipe (CMP). USACE San Joaquin O&M Manual, Unit 601 Part 1 (SJR601.1), 1967, Revised 25 May 2011, (HLM 15.29), listed as a 24-inch CMP].

View of waterward side.

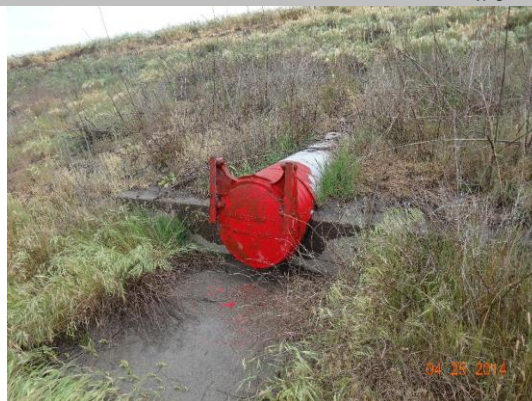
Photo 2 of 3 : UCIP\_SP\_2021\_62672\_65457.jpg

Concrete headwall, flap gate, and concrete apron located on waterward side.

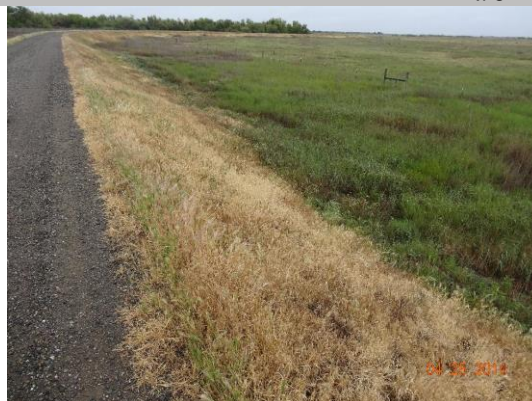
Photo 3 of 3 : UCIP\_SP\_2021\_62672\_65458.jpg

View of landward side.

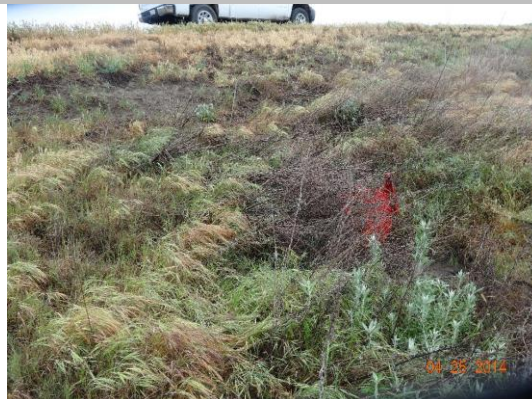
Photo 2 of 3 : UCIP\_SP\_2021\_62673\_65463.jpg

UCIP Comments: 11/16/2020 Pipe status is still Non-Urgent. Dense vegetation on LS toe and slope inhibited proper inspection of pipe. No permit was found authorizing this encroachment. CVFPB will need to review crossing to determine owner. DWR DMP has not found internal issues, LOF between 1 and 2.04/25/2014 Dense vegetation limits the inspector's visibility to identify signs of pipe failure (leaks) along the waterward and landward slopes. Recommend removing vegetation along pipe alignment to conduct proper inspection of structure. (O. Magana - DWR UCIP)

View of waterward slope covered by dense vegetation.

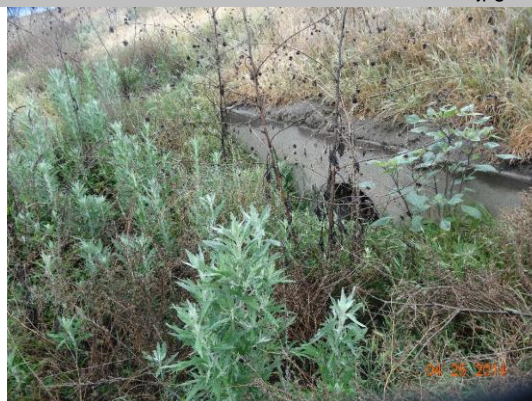
Photo 3 of 3 : UCIP\_SP\_2021\_62673\_65462.jpg

Concrete headwall visible on landward toe--dense vegetation blocking inlet.

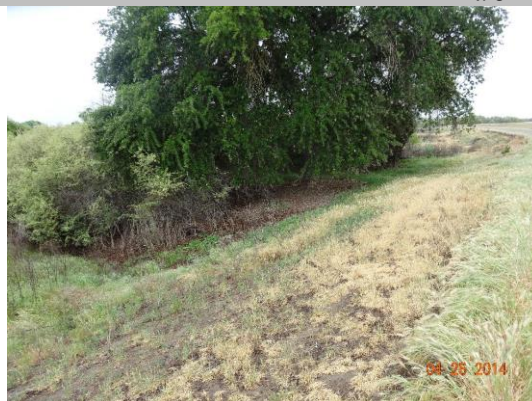
Photo 1 of 3 : UCIP\_SP\_2021\_62674\_65471.jpg

Comment Code						
Inspector Comment						
FS_ID:62674 DS_ID:19645 EP_NO: N/A Repair Type: Non-Urgent Crossing Status: Found UCIP Comments: 11/16/2020 Pipe status is still Non-Urgent, however corrosion observed in pipe inlet at LS toe. Some burrowing activity on both LS and WS slope. No permit was found authorizing this encroachment. CVFPB will need to review crossing to determine owner. DWR DMP has not completed an internal inspection of the pipe but is scheduled for 2021. (B. Singh - GEI, O. Magana - DWR UCIP)04/25/2014 Dense vegetation limits the inspector's visibility to identify signs of pipe failure (leaks) along the waterward and landward slope. Recommend removing vegetation along pipe alignment to conduct proper inspection of structure. (O. Magana - DWR UCIP) FIELD_STRUCT_DESC: 24-inch corrugated metal gravity drainage pipe through the levee, 11 feet below the crown. Flap gate on the waterside (WS) end. Brass cap No. 60 bench mark (BM) on the headwall on the landside (LS). [Additional Reference(s): DWR Levee Log, 2002 (HLM 15.82), listed as a 24-inch corrugated metal pipe (CMP). USACE San Joaquin O&M Manual, Unit 601 Part 1 (SJR601.1), 1967, Revised 25 May 2011, (HLM 15.81), listed as a 24-inch CMP]. FS Date: 11/16/2020

View of waterward side.

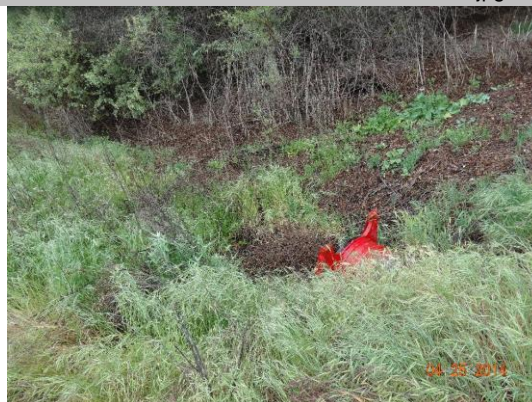
Photo 2 of 3 : UCIP\_SP\_2021\_62674\_65470.jpg

Flap gate visible on waterward side.

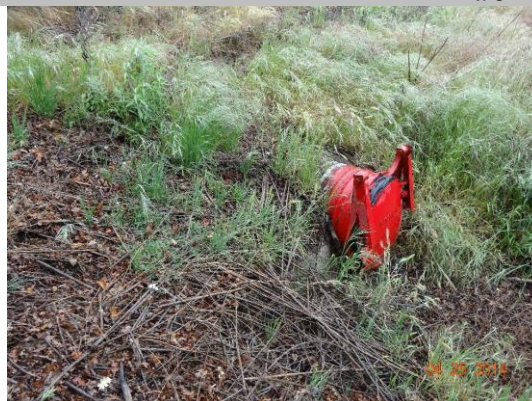
Photo 3 of 3 : UCIP\_SP\_2021\_62674\_65469.jpg

Side view of pipe and flap gate on waterward side.

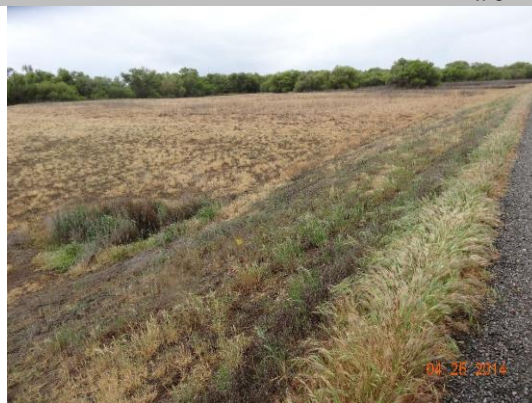
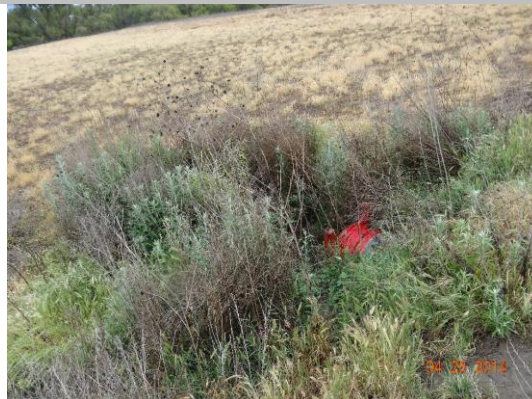
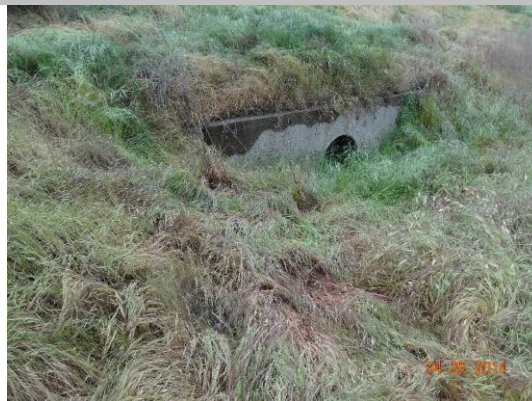
Photo 1 of 3 : UCIP\_SP\_2021\_62675\_65476.jpg

FS\_ID:62675  
 DS\_ID:19646  
 EP\_NO: N/A  
 Repair Type: Urgent  
 Crossing Status: Found  
 UCIP Comments: 11/16/2020 Pipe status is Urgent. DWR DMP has found integrity issues, LOF between 5 and 6. Crossing will be monitored until funding becomes available for removal. Burrowing activity observed on LS and WS slopes. No permit was found authorizing this encroachment. CVFPB will need to review crossing to determine owner. (B. Singh - GEI, O. Magana - DWR UCIP)04/25/2014 Dense vegetation limits the inspector's visibility to identify signs of pipe failure (leaks) along the waterward and landward slopes. Recommend removing vegetation along pipe alignment to conduct proper inspection of structure and appurtenances. (O. Magana - DWR UCIP)  
 FIELD\_STRUCT\_DESC: 24-inch corrugated metal gravity drainage pipe through the levee, 11.3 feet below the crown. Flap gate on the waterside (WS) end. Brass cap No. 50 bench mark (BM) on the headwall on the landside (LS). [Additional Reference(s): DWR Levee Log, 2002 (HLM 16.09), listed as a 24-inch corrugated metal pipe (CMP). USACE San Joaquin O&M Manual, Unit 601 Part 1 (SJR601.1), 1967, Revised 25 May 2011, (HLM 16.09), listed as a 24-inch pipe].

View of waterward side.

Flap gate visible on waterward toe.

View of landward side.

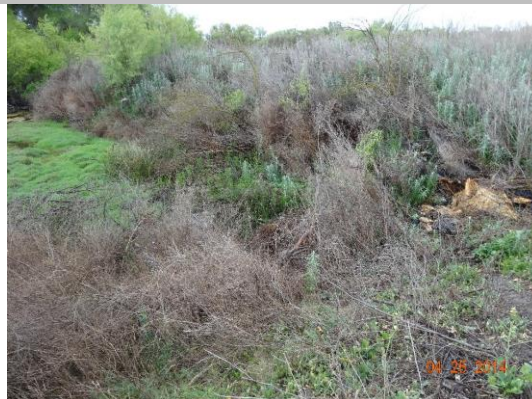
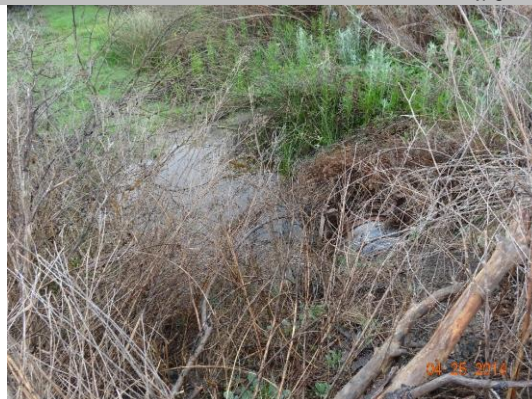
Photo 1 of 3 : UCIP\_SP\_2021\_62671\_65480.jpg

FS\_ID:62671  
DS\_ID:19647  
EP\_NO: N/A  
Repair Type: Non-Urgent  
Crossing Status: Found  
UCIP Comments: 11/16/2020 DMP record missing, need to verify if pipe inspections have been completed. Pipe and flapgate on WS toe were under water and there is dense vegetation on the LS slope and toe, inhibiting inspection. Records indicate the pipe was cleaned and inspected in Q2 2020 but is missing from updated maps. Pipe status is still Non-Urgent. No permit was found authorizing this encroachment. CVFPB will need to review crossing to determine owner. (B. Singh - GEI, O. Magana - DWR UCIP)04/25/2014 Dense vegetation limits the inspector's visibility to identify signs of pipe failure (leaks) along the waterward and landward slopes. Recommend removing vegetation along pipe alignment to conduct proper inspection of structure. Unable to find pipe on landward side. (O. Magana - DWR UCIP)  
FIELD\_STRUCT\_DESC: 24-inch corrugated metal gravity drainage pipe through the levee, 14.7 feet below the crown. Flap gate on the waterside (WS) end. Brass cap No. 50 bench mark (BM) on the headwall on the landside (LS). [Additional Reference(s): DWR Levee Log, 2002 (HLM 16.16), listed as a 24-inch corrugated metal pipe (CMP). USACE San Joaquin O&M Manual, Unit 601 Part 1 (SJR601.1), 1967, Revised 25 May 2011, (HLM 16.15), listed as a 24-inch pipe].

View of waterward side.

Crossing visible on waterward side under dense vegetation.

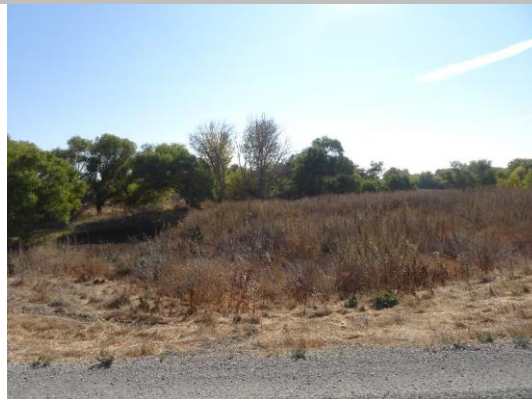
Photo 2 of 3 : UCIP\_SP\_2021\_62676\_90814.jpg

View toward WS toe. Pipe not found at WS toe and dense vegetation.

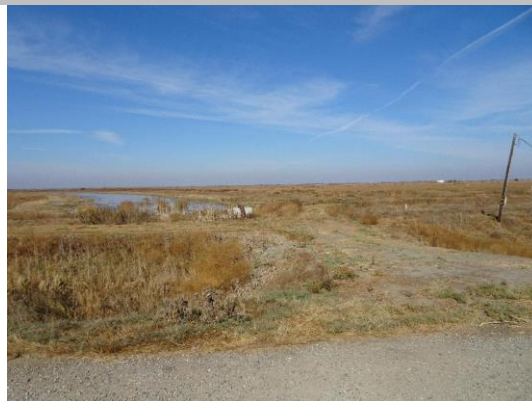
Photo 3 of 3 : UCIP\_SP\_2021\_62676\_90815.jpg

View toward LS toe. Concrete cone with 12" pipe found.

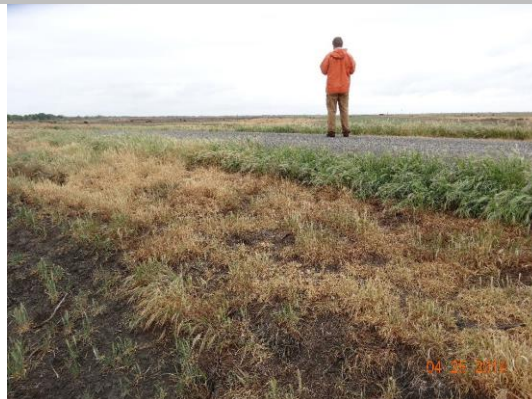
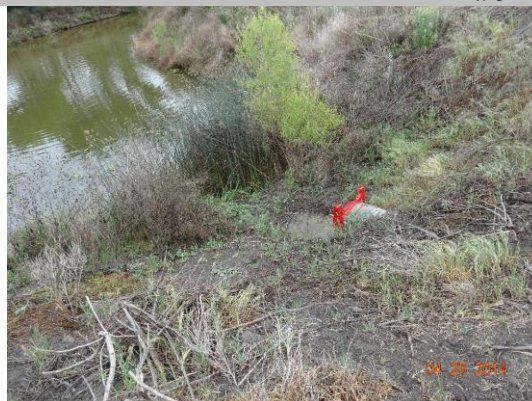
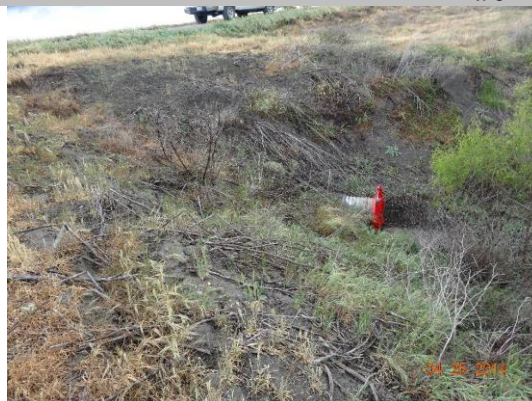
Photo 1 of 3 : UCIP\_SP\_2021\_62677\_66288.jpg

FS\_ID:62677  
DS\_ID:19648  
EP\_NO: N/A  
Repair Type: Non-Urgent  
Crossing Status: Found  
UCIP Comments: 11/16/2020 Pipe was not found at both LS and WS toes, possibly due to the dense vegetation. Recommend vegetation removal for proper inspections. DWR DMP has not completed an internal inspection of the pipe but is scheduled for 2021. No permit was found authorizing this encroachment. CVFPB will need to review crossing to determine owner. (B. Singh - GEI, O. Magana - DWR UCIP)04/25/2014 Dense vegetation limits the inspector's visibility to identify signs of pipe failure (leaks) along the waterward and landward slopes. Recommend removing vegetation along pipe alignment to conduct proper inspection of structure. Unable to find pipe on landward side. (O. Magana - DWR UCIP)  
FIELD\_STRUCT\_DESC: 24-inch corrugated metal gravity drainage pipe through the levee, 11.4 feet below the crown. Flap gate on the waterside (WS) end. Brass cap No. 50 bench mark (BM) on the headwall on the landside (LS). [Additional Reference(s): DWR Levee Log, 2002 (HLM 16.73), listed as a 24-inch corrugated metal pipe (CMP). USACE San Joaquin O&M Manual, Unit 601 Part 1 (SJR601.1), 1967, Revised 25 May 2011, (HLM 16.72), listed as a 24-inch CMP].

View of levee crown at crossing.

View of waterward side.

View of flap gate visible on waterward side.

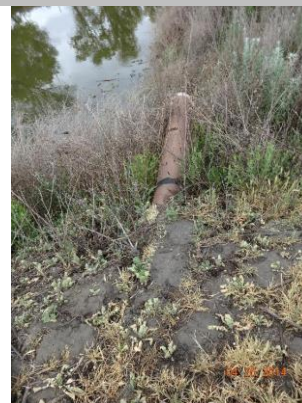
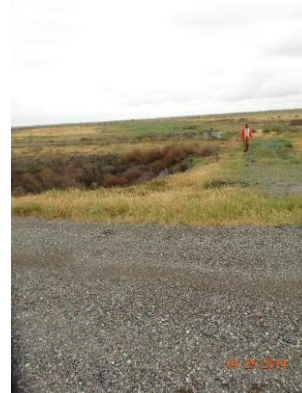
Photo 1 of 2 : UCIP\_SP\_2021\_61888\_71487.jpg

FS\_ID:61888  
DS\_ID:24870  
EP\_NO: N/A  
Repair Type: Non-Urgent  
Crossing Status: Found  
UCIP Comments: 04/25/2014 Need to contact owner to determine status and reason for crossing. (O. Magana - DWR UCIP)  
FIELD\_STRUCT\_DESC: 12-inch steel gravity drainage pipe through the levee, at an unknown depth. Concrete standpipe visible on the landside (LS). This pipe was field discovered.  
FS Date: 4/25/2014

View of pipe located on waterward side.

View of landward side.

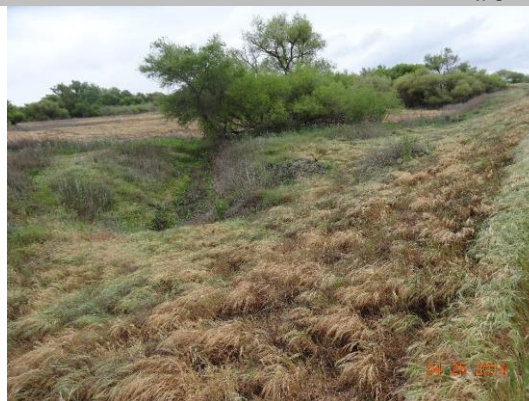
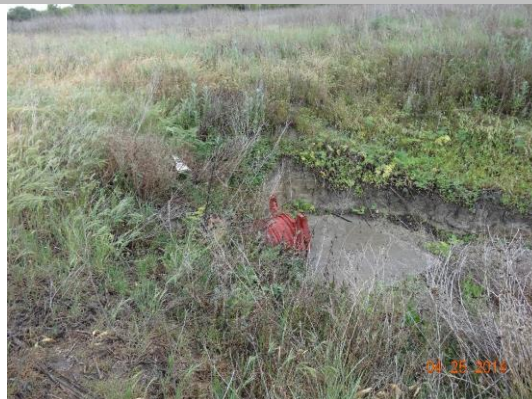
Photo 1 of 3 : UCIP\_SP\_2021\_62678\_65518.jpg

UCIP Comments: 11/16/2020 Pipe status is still Non-Urgent. No permit was found authorizing this encroachment. CVFPB will need to review crossing to determine owner. DWR DMP has not found internal issues, LOF between 1 and 2. Recommend inspection in 5 years. (B. Singh - GEI, O. Magana - DWR UCIP)04/25/2014 Dense vegetation limits the inspector's visibility to identify signs of pipe failure (leaks) along the waterward and landward slopes. Concrete headwall is buried by dense vegetation. Recommend removing vegetation along pipe alignment to conduct proper inspection of structure. (O. Magana - DWR UCIP)

View of waterward side.

Flap gate visible on waterward side.

View of landward side.

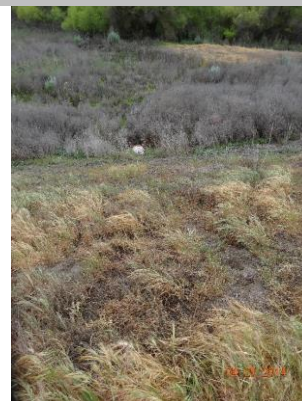
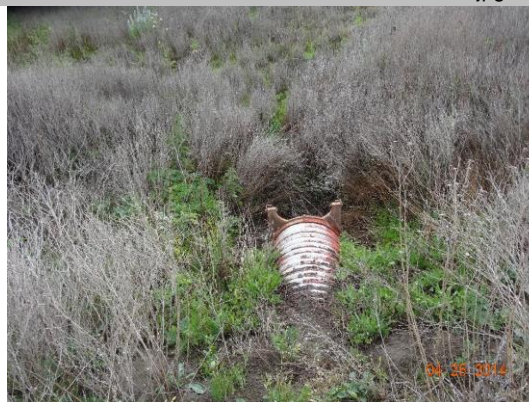
Photo 1 of 3 : UCIP\_SP\_2021\_62681\_65525.jpg

FS\_ID:62681  
DS\_ID:19578  
EP\_NO: N/A  
Repair Type: Non-Urgent  
Crossing Status: Found  
UCIP Comments: 11/16/2020 Pipe status is still Non-Urgent. No permit was found authorizing this encroachment. CVFPB will need to review crossing to determine owner. DWR DMP has not found internal issues, LOF between 1 and 2. Recommend inspection in 5 years. (B. Singh - GEI, O. Magana - DWR UCIP)04/25/2014 Dense vegetation limits the inspector's visibility to identify signs of pipe failure (leaks) along the waterward and landward slopes. Recommend removing vegetation along pipe alignment to conduct proper inspection of structure. Sediment buildup inside pipe visible from landward side. Recommend clearing pipe. (O. Magana - DWR UCIP)  
FIELD\_STRUCT\_DESC: 24-inch corrugated metal gravity drainage pipe through the levee, 11.5 feet below the crown. Flap gate on the waterside (WS) end. Brass cap No. 50 bench mark (BM) on the headwall on the landside (LS). [Additional Reference(s): DWR Levee Log, 2002 (HLM 17.20), listed as a 24-inch corrugated metal pipe (CMP). USACE San Joaquin O&M Manual, Unit 601 Part 1 (SJR601.1), 1967, Revised 25 May 2011, (HLM 17.19), listed as a 24-inch CMP].

View of waterward side.

Pipe visible on waterward side.

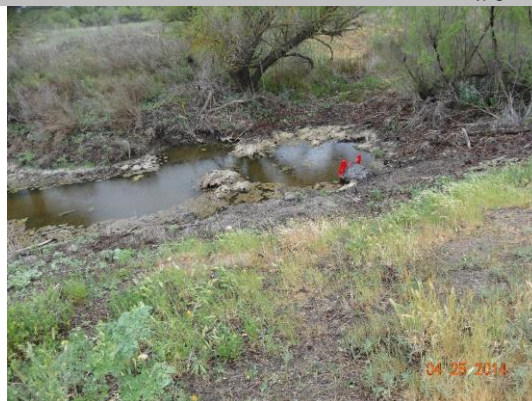
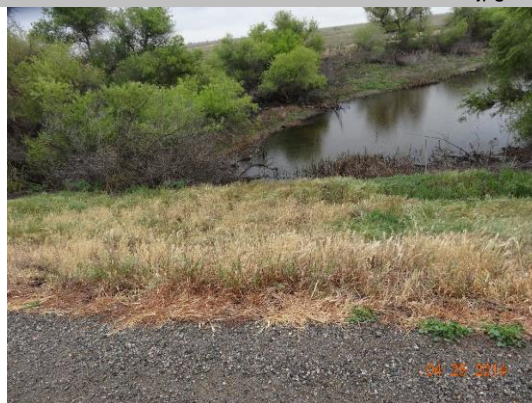
Photo 2 of 3 : UCIP\_SP\_2021\_62680\_65552.jpg

Pipe visible on waterward side.

View of landward side.

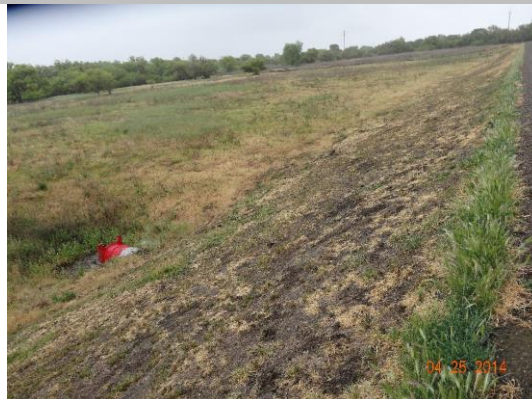
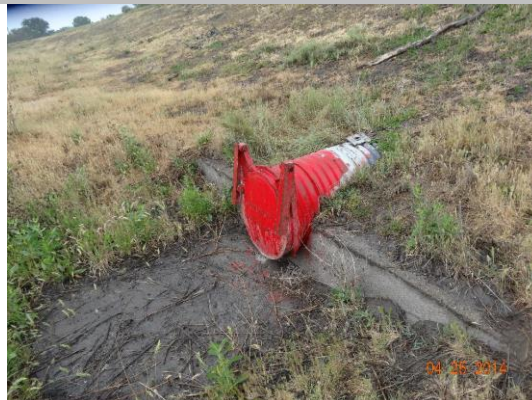
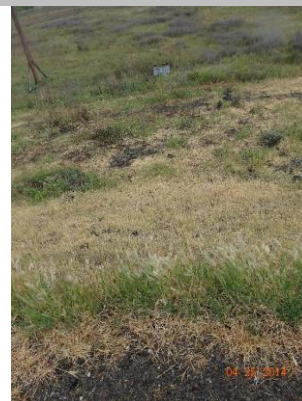
Photo 1 of 3 : UCIP\_SP\_2021\_62682\_65547.jpg

FS\_ID:62682  
DS\_ID:19580  
EP\_NO: N/A  
Repair Type: Urgent  
Crossing Status: Found  
UCIP Comments: 11/16/2020 Pipe status is Urgent. Pipe collapse visible at LS toe through LS pipe riser, and in sinkhole 1 foot up-slope of the riser. No permit was found authorizing this encroachment. CVFPB will need to review crossing to determine owner. DWR DMP has not completed an internal inspection of the pipe but is scheduled for 2021. (B. Singh - GEI, O. Magana - DWR UCIP)04/25/2014  
Dense vegetation limits the inspector's visibility to identify signs of pipe failure (leaks) along the landward slope. Recommend removing vegetation along pipe alignment to conduct proper inspection of structure. (O. Magana - DWR UCIP)  
FIELD\_STRUCT\_DESC: 24-inch corrugated metal gravity drainage pipe through the levee, 9.5 feet below the crown. Flap gate on the waterside (WS) end. Brass cap No. 50 bench mark (BM) on the headwall on the landside (LS). [Additional Reference(s): DWR Levee Log, 2002 (HLM 17.53), listed as a 24-inch corrugated metal pipe (CMP). USACE San Joaquin O&M Manual, Unit 601 Part 1 (SJR601.1), 1967, Revised 25 May 2011, (HLM 17.53), listed as a 24-inch CMP].

View of waterward side.

Flap gate visible on waterward side.

View of landward side--riser at levee toe.

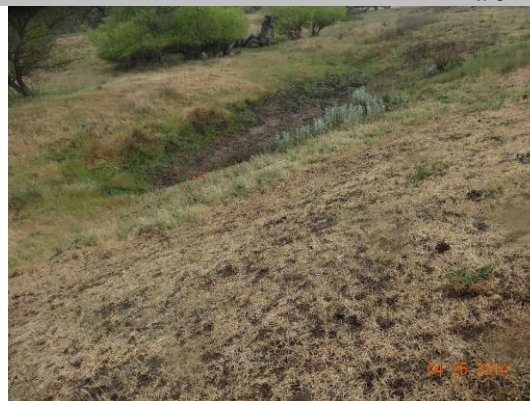
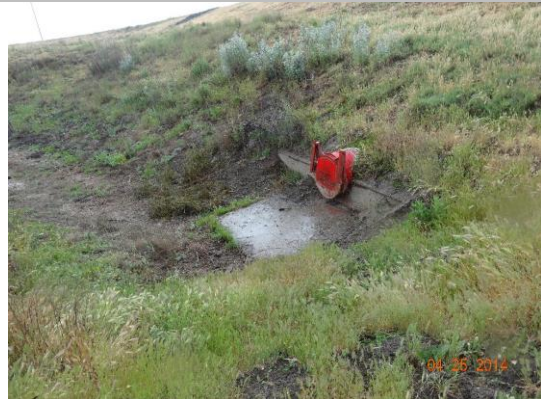
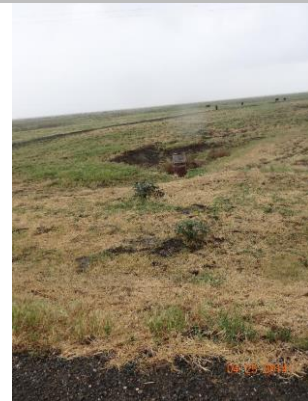
Photo 1 of 3 : UCIP\_SP\_2021\_62683\_65557.jpg

FS\_ID:62683  
DS\_ID:19581  
EP\_NO: N/A  
Repair Type: Urgent  
Crossing Status: Found  
UCIP Comments: 11/16/2020 Pipe status is Urgent. Considerable damage to pipe interior observed from LS toe. DWR DMP has found integrity issues, LOF between 5 and 6. Crossing will be monitored until funding becomes available for removal. No permit was found authorizing this encroachment. CVFPB will need to review crossing to determine owner. (B. Singh - GEI, O. Magana - DWR UCIP)04/25/2014 Need to contact owner. Recommend investigating integrity of pipe wall through levee heavy corrosion visible from landward side. (O. Magana - DWR UCIP)  
FIELD\_STRUCT\_DESC: 24-inch corrugated metal gravity drainage pipe through the levee, 11.5 feet below the crown. Flap gate on the waterside (WS) end. Brass cap No. 50 bench mark (BM) on the headwall on the landside (LS). [Additional Reference(s): DWR Levee Log, 2002 (HLM 18.21), listed as a 24-inch corrugated metal pipe (CMP). USACE San Joaquin O&M Manual, Unit 601 Part 1 (SJR601.1), 1967, Revised 25 May 2011, (HLM 18.19), listed as a 24-inch CMP].

View of waterward side.

Flap gate visible on waterward side.

View of landward side.

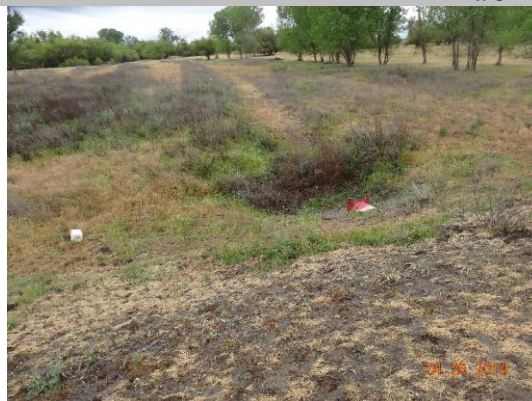
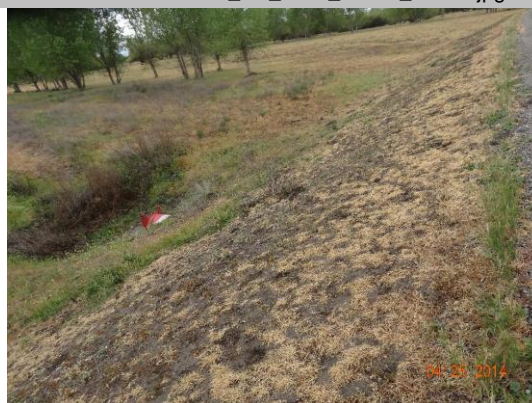
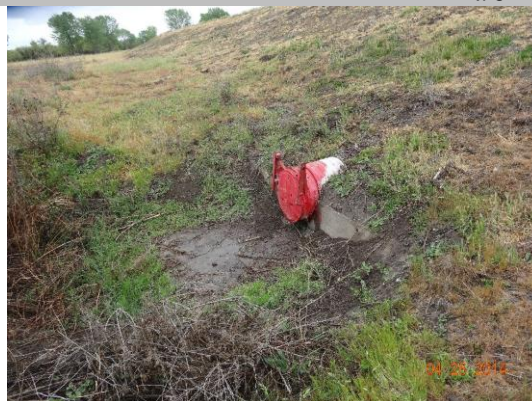
Photo 1 of 3 : UCIP\_SP\_2021\_62684\_65563.jpg

FS\_ID:62684  
DS\_ID:19582  
EP\_NO: N/A  
Repair Type: Urgent  
Crossing Status: Found  
UCIP Comments: 11/16/2020 Pipe status is still Urgent. DWR DMP has found integrity issues, LOF between 5 and 6. Damage not observed in field inspection. Crossing will be monitored until funding becomes available for removal. No permit was found authorizing this encroachment. CVFPB will need to review crossing to determine owner. (B. Singh - GEI, O. Magana - DWR UCIP)  
FIELD\_STRUCT\_DESC: 24-inch corrugated metal gravity drainage pipe through the levee, 9.4 feet below the crown. Flap gate on the waterside (WS) end. Brass cap No. 50 bench mark (BM) on the headwall on the landside (LS). [Additional Reference(s): DWR Levee Log, 2002 (HLM 18.47), listed as a 24-inch corrugated metal pipe (CMP). USACE San Joaquin O&M Manual, Unit 601 Part 1 (SJR601.1), 1967, Revised 25 May 2011, (HLM 18.45), listed as a 24-inch CMP].

View of waterward side.

View of waterward slope.

Flap gate visible on waterward side.
