# Flood Control Project Maintenance Levee Inspections LMA District Cover Sheet

## Lower San Joaquin Levee District

**Flood Control Project Maintenance  
Levee Inspections  
Unit Cover Sheet**

Waterway			Bank	Unit Miles
Unit No. 01 San Joaquin River			Right	22.52
	Spring (March - May)	Summer (June - August)	(September - November) Fall	Winter (December - February)
Unit Maintenance Rating (Fall Only)				
Date of Inspection	5/4/2021 - 5/4/2021			
DWR Inspector	Corey Fujitani			
Accompanied By

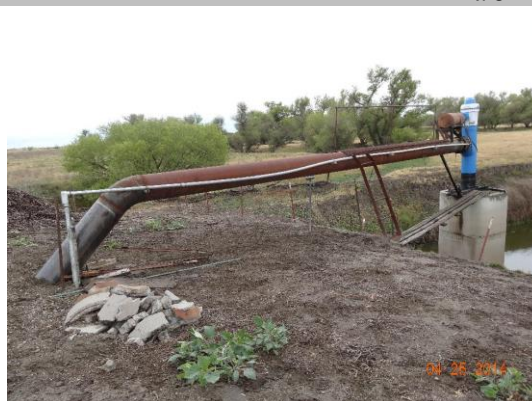
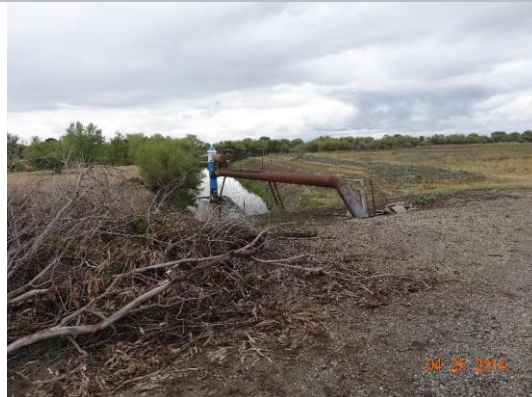
Photo 1 of 3 : UCIP\_SP\_2021\_62748\_71472.jpg

FS\_ID:62748  
 DS\_ID:19592  
 EP\_NO: 13966  
 Repair Type: Non-Urgent  
 Crossing Status: Found  
 UCIP Comments: 11/16/2020 Walkway along and to top of pipe length has been replaced. Erosion observed below fencing near standpipe at LS toe. CVFPB will need to review crossing to determine owner. (B. Singh - GEI, O. Magana - DWR UCIP)  
 FIELD\_STRUCT\_DESC: 16-inch coated steel irrigation discharge pipe through the levee, 2 feet below the crown. Cutoff walls around the pipe at the center of the levee. Siphon breaker on apex of pipe on the landside (LS) shoulder. Inlet channel from river on the waterside (WS), perpendicular to the levee. Pump off the WS toe on an earth pad between the inlet channel and levee section. Polyvinyl chloride (PVC) electrical conduit through the levee. Access ramp immediately downstream of the pump pad. (Plans to install an irrigation pumping unit on the WS and a 16-inch irrigation discharge pipe through the levee authorized under Permit No. 13966, 1985 - D. and D. Land and Water, Inc.). [Additional Reference(s): DWR Levee Log, 2002 (HLM 18.79), listed as a 16-inch pipe].

Pipe, electrical conduit, standpipe, and pump visible on waterward side.

View of waterward side.

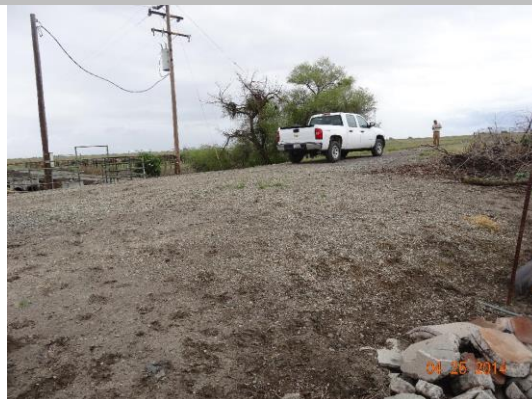
Photo 3 of 3 : UCIP\_SP\_2021\_62748\_71464.jpg

LM Start	<b>18.77</b>	Rating **	M	Issue No.	<b>83 (cont)</b>
LM End	<b>18.77</b>	Issue Type +	En	Location *

View of levee crown.

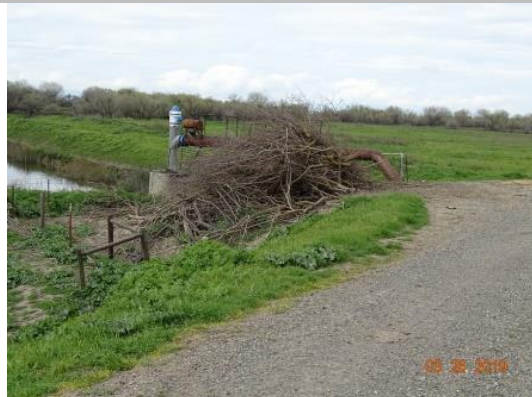
Photo 1 of 1 : SP\_2021\_NA0010\_118\_134\_20210308\_00028.jpg

LM Start	18.77	Rating **	U	Issue No.	134
LM End	18.77	Issue Type +	En	Location *	WS
Category	Earthen Levee			GPS Latitude/Longitude	
				Start	End
Item	Encroachments			37.205064 °	37.205064 °
				-120.762721 °	-120.762721 °
DWR ID	DWR_NA0010_01_s_2019_134				
Comment Code					
PR : Prunings					
Inspector Comment

View of prunings on waterside slope. (Spring 2019)

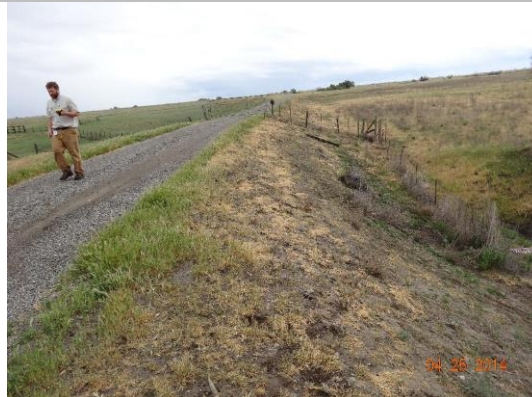
Photo 1 of 3 : UCIP\_SP\_2021\_62749\_65627.jpg

FS\_ID:62749  
DS\_ID:19593  
EP\_NO: N/A  
Repair Type: Non-Urgent  
Crossing Status: Found  
UCIP Comments: 11/16/2020 Pipe status is still Urgent. DWR DMP has found integrity issues, LOF between 4 and 5. Crossing will be monitored until funding becomes available for rehabilitation. No permit was found authorizing this encroachment. CVFPB will need to review crossing to determine owner. (B. Singh - GEI, O. Magana - DWR UCIP)04/25/2014 Dense vegetation limits the inspector's visibility to identify signs of pipe failure (leaks) along the landward slope. Recommend removing vegetation along pipe alignment to conduct proper inspection of structure. (O. Magana - DWR UCIP)  
FIELD\_STRUCT\_DESC: 24-inch corrugated metal gravity drainage pipe through the levee, 12 feet below the crown. Flap gate on the waterside (WS) end. Brass cap No. 50 bench mark (BM) on the headwall on the landside (LS). [Additional Reference(s): DWR Levee Log, 2002 (HLM 18.80), listed as a 24-inch corrugated metal pipe (CMP). USACE San Joaquin O&M Manual, Unit 601 Part 1 (SJR601.1), 1967, Revised 25 May 2011, (HLM 18.79), listed as a 24-inch CMP].

Overview of levee crown and waterward slope.

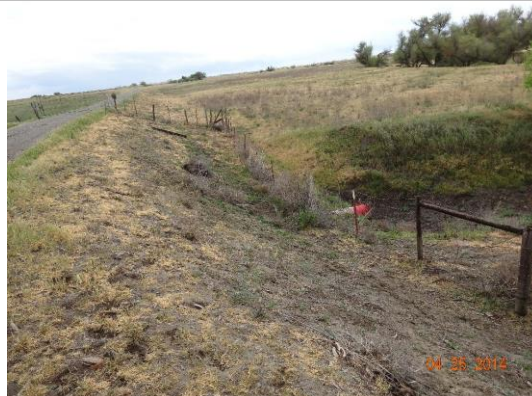
Photo 2 of 3 : UCIP\_SP\_2021\_62749\_65623.jpg

View of waterward side.

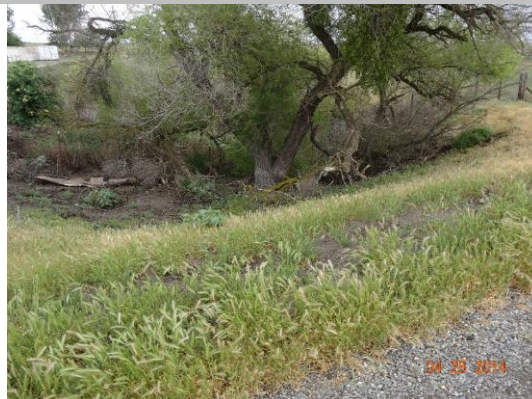
Photo 3 of 3 : UCIP\_SP\_2021\_62749\_65626.jpg

Overview of landward side.

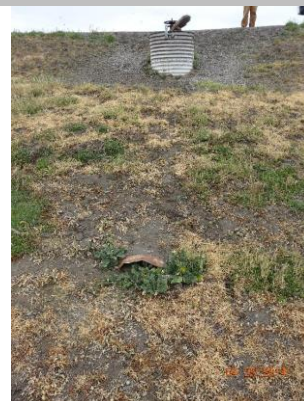
Photo 1 of 3 : UCIP\_SP\_2021\_62685\_65631.jpg

FS\_ID:62685  
DS\_ID:19594  
EP\_NO: N/A  
Repair Type: Non-Urgent  
Crossing Status: Found  
UCIP Comments: 11/16/2020 Pipe status is still Non-Urgent. Sediment build-up observed at LS inlet; recommend sediment removal. No permit was found authorizing this encroachment. CVFPB will need to review crossing to determine owner. DWR DMP has not completed an internal inspection of the pipe but is scheduled for 2021. (B. Singh - GEI, O. Magana - DWR UCIP)04/25/2014 Non-functional crossing--pipe is buried on waterward side. Sediment buildup in pipe visible from landward side. Need to coordinate with owner to determine status. If crossing is no longer in use, owner will need to coordinate with DWR Inspector and CVFPB to properly abandon. (O. Magana - DWR UCIP) FIELD\_STRUCT\_DESC: 24-inch corrugated metal gravity drainage pipe through the levee, 13 feet below the crown. Flap gate on the waterside (WS) end. Brass cap No. 40 bench mark (BM) on the headwall on the landside (LS). [Additional Reference(s): DWR Levee Log, 2002 (HLM 19.18), listed as a 24-inch corrugated metal pipe (CMP). USACE San Joaquin O&M Manual, Unit 601 Part 1 (SJR601.1), 1967, Revised 25 May 2011, (HLM 19.17), listed as a 24-inch CMP]. FS Date: 11/16/2020

View of waterward slope. CMP riser and pipe visible.

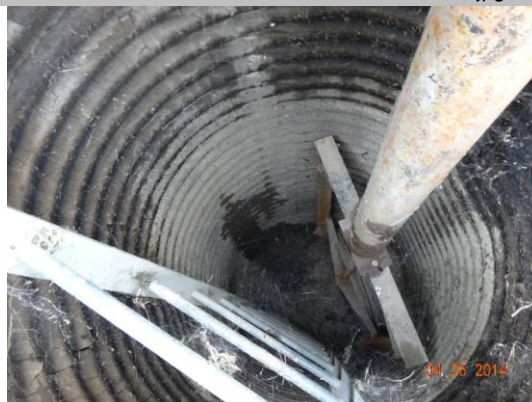
Photo 2 of 3 : UCIP\_SP\_2021\_62685\_65632.jpg

Inside view of CMP riser.

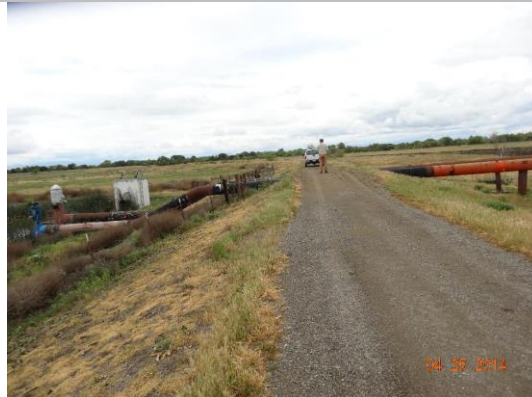
Photo 2 of 3 : UCIP\_SP\_2021\_62689\_71420.jpg

Overview of levee crown at crossing.

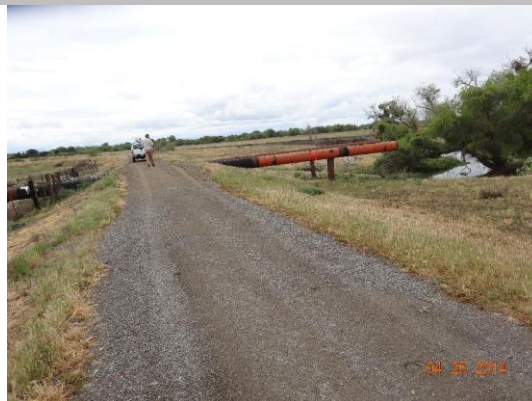
Photo 3 of 3 : UCIP\_SP\_2021\_62689\_71423.jpg

View of waterward slope.

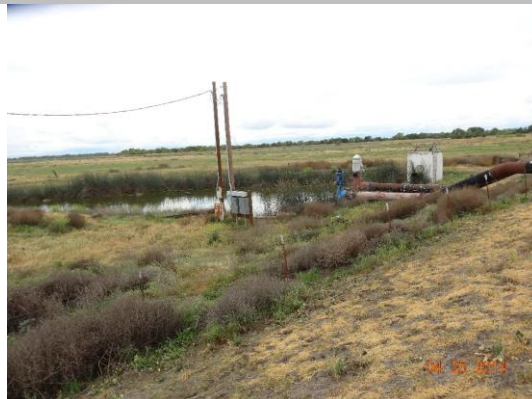
Photo 1 of 3 : UCIP\_SP\_2021\_62690\_71427.jpg

Comment Code					
Inspector Comment					
FS_ID:62690 DS_ID:24872 EP_NO: N/A Repair Type: Non-Urgent Crossing Status: Found UCIP Comments: 11/16/2020 Pipe status is still Non-Urgent. Pipe measured as 24 inches in diameter at LS outlet. No permit was found authorizing this encroachment. CVFPB will need to review crossing to determine owner. DWR DMP has not completed an internal inspection of the pipe. (B. Singh - GEI, O. Magana - DWR UCIP)04/25/2014 New crossing found during field inspection--Need to contact owner to obtain additional information about crossing. (O. Magana - DWR UCIP) FIELD_STRUCT_DESC: 2 of 2: 20-inch steel drainage discharge pipe through the levee, at an unknown depth. Pump station and electrical panel on the landside (LS). This pipe was field discovered. FS Date: 11/16/2020

View of landward side.

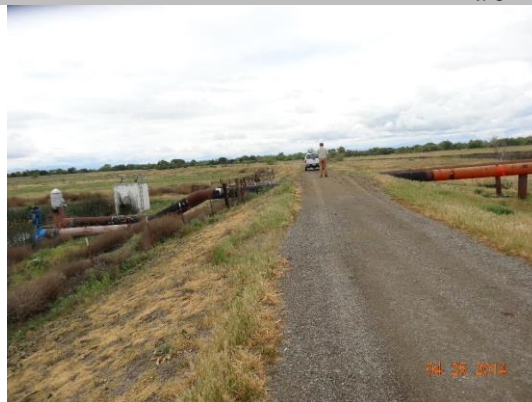
Photo 2 of 3 : UCIP\_SP\_2021\_62690\_71425.jpg

View of levee crown at crossings.

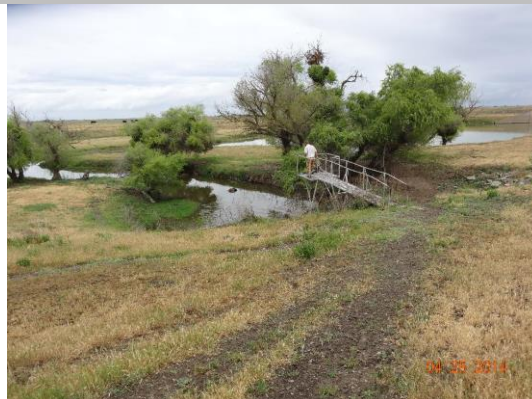
Photo 2 of 3 : UCIP\_SP\_2021\_62688\_65636.jpg

View of waterward side.

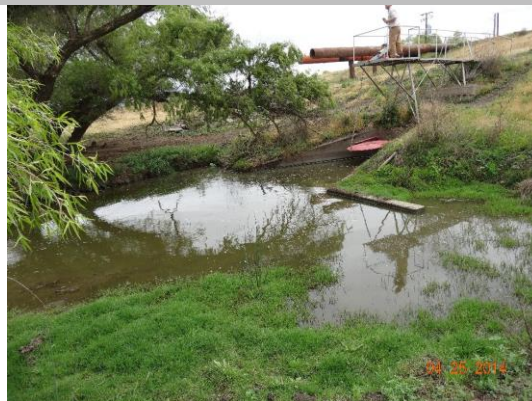
Photo 3 of 3 : UCIP\_SP\_2021\_62688\_65635.jpg

View of flap gate visible on waterward side.

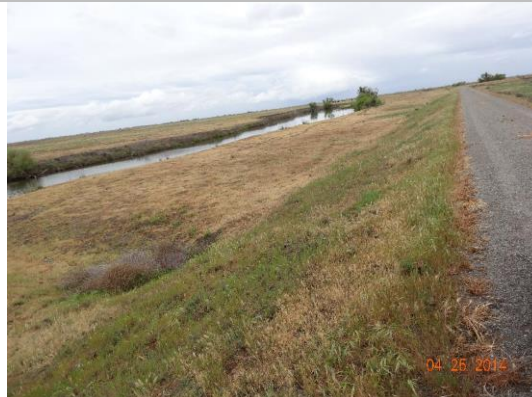
Photo 1 of 3 : UCIP\_SP\_2021\_62691\_65641.jpg

FS\_ID:62691  
DS\_ID:19596  
EP\_NO: N/A  
Repair Type: Non-Urgent  
Crossing Status: Found  
UCIP Comments: 11/16/2020 Pipe status is still Non-Urgent. No permit was found authorizing this encroachment. CVFPB will need to review crossing to determine owner. DWR DMP has not found internal issues, LOF between 1 and 2. Recommend inspection in 5 years. (B. Singh - GEI, O. Magana - DWR UCIP)04/25/2014 Dense vegetation limits the inspector's visibility to identify signs of pipe failure (leaks) along the waterward slope. Recommend removing vegetation along pipe alignment to conduct proper inspection of structure. Dense vegetation blocks both waterward and landward headwalls. Sediment buildup in pipe visible from landward side. (O. Magana - DWR UCIP)  
FIELD\_STRUCT\_DESC: 24-inch corrugated metal gravity drainage pipe through the levee, 8 feet below the crown. Flap gate on the waterside (WS) end. Brass cap No. 40 bench mark (BM) on the headwall on the landside (LS). [Additional Reference(s): DWR Levee Log, 2002 (HLM 19.54), listed as a 24-inch corrugated metal pipe (CMP). USACE San Joaquin O&M Manual, Unit 601 Part 1 (SJR601.1), 1967, Revised 25 May 2011, (HLM 19.54), listed as a 24-inch CMP].

View of waterward side.

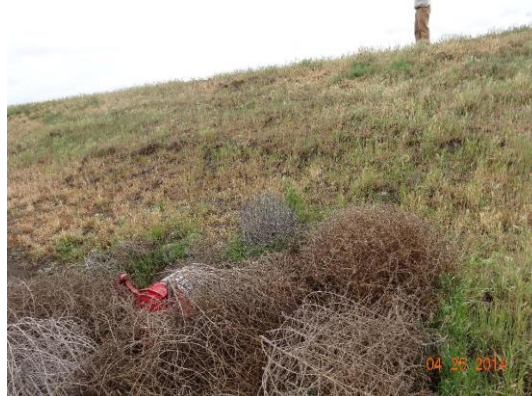
Photo 2 of 3 : UCIP\_SP\_2021\_62691\_65640.jpg

Flap gate visible on waterward side--potential erosion present on slope.

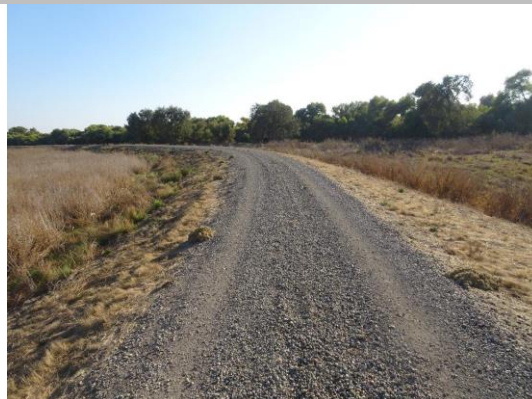
Photo 2 of 3 : UCIP\_SP\_2021\_62692\_90896.jpg

Overview of levee crown

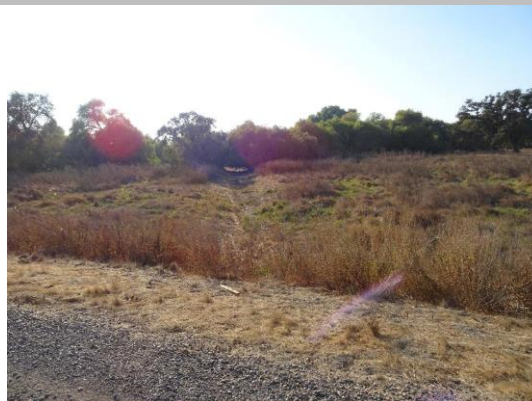
Photo 3 of 3 : UCIP\_SP\_2021\_62692\_90897.jpg

View waterward

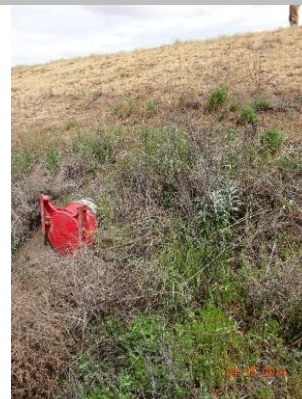
Photo 2 of 3 : UCIP\_SP\_2021\_62693\_65647.jpg

FS\_ID:62693  
DS\_ID:19598  
EP\_NO: N/A  
Repair Type: Non-Urgent  
Crossing Status: Found  
UCIP Comments: 11/16/2020 Pipe status is still Non-Urgent. Limited access due to steep slopes. No permit was found authorizing this encroachment. CVFPB will need to review crossing to determine owner. DWR DMP has not completed an internal inspection of the pipe but is scheduled for 2021. (B. Singh - GEI, O. Magana - DWR UCIP)04/25/2014 Recommend removing vegetation and sediment buildup from both waterward and landward concrete headwalls. (O. Magana - DWR UCIP)  
FIELD\_STRUCT\_DESC: 24-inch corrugated metal gravity drainage pipe through the levee, 8.5 feet below the crown. Flap gate on the waterside (WS) end. Brass cap No. 40 bench mark (BM) on the headwall on the landside (LS). [Additional Reference(s): DWR Levee Log, 2002 (HLM 20.19), listed as a 24-inch corrugated metal pipe (CMP). USACE San Joaquin O&M Manual, Unit 601 Part 1 (SJR601.1), 1967, Revised 25 May 2011, (HLM 20.18), listed as a 24-inch CMP].

Flap gate visible on WS toe.

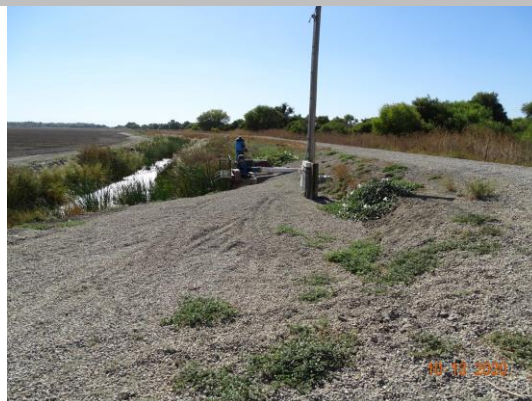
Photo 1 of 1 : SP\_2021\_NA0010\_118\_1184\_20210308\_00031.jpg

LM Start	20.25	Rating **	M	Issue No.	1184
LM End	20.25	Issue Type +	En	Location *	LS
Category	Earthen Levee			GPS Latitude/Longitude	
				Start	End
Item	Encroachments			37.193657 °	37.193657 °
				-120.760138 °	-120.760138 °
DWR ID	DWR_NA0010_01_s_2015_1184				
Comment Code					
RA : Ramp					
Inspector Comment					
Landowner installed unauthorized ramp on landside slope and toe.

Ramp cut into to the landside slope to access irrigation ditch at the landside toe. (Fall 2020)

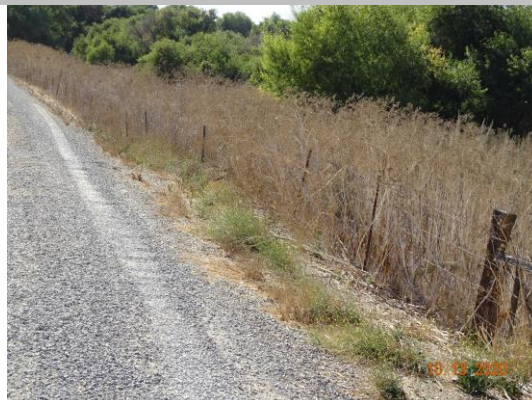
Photo 1 of 1 : SP\_2021\_NA0010\_118\_106\_20210308\_00014.jpg

LM Start	20.25	Rating **	M	Issue No.	106
LM End	22.51	Issue Type +	En	Location *	WS
Category	Earthen Levee			GPS Latitude/Longitude	
				Start	End
Item	Encroachments			37.193663 °	37.166957 °
				-120.760148 °	-120.750080 °
DWR ID	DWR_NA0010_01_f_2020_106				
Comment Code					
FE : Fence					
Inspector Comment

Barbed wire fence along the waterside slope. (Fall 2020)

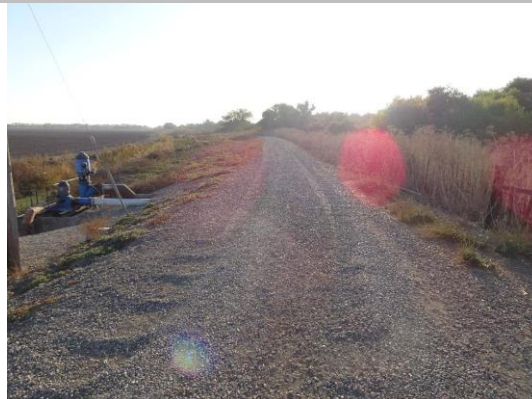
Photo 1 of 3 : UCIP\_SP\_2021\_62717\_91024.jpg

LM Start	20.26	Rating **	M	Issue No.	92	
LM End	20.26	Issue Type +	En	Location *		
Category	Supplemental			GPS Latitude/Longitude		
				Start		End
Item	DWR UCIP Field Study			37.193618 °		37.193618 °
				-120.760284 °		-120.760284 °
DWR ID	19726					
Comment Code						
Inspector Comment						
FS_ID:62717 DS_ID:19726 EP_NO: N/A Repair Type: Non-Urgent Crossing Status: Not Found UCIP Comments: 11/16/2020 PVC pipe not found. No permit was found authorizing this encroachment. CVFPB will need to review crossing to determine owner. DWR DMP has not completed an internal inspection of the pipe. (B. Singh - GEI, O. Magana - DWR UCIP) FIELD_STRUCT_DESC: Polyvinyl chloride (PVC) gravity drainage pipe of an unknown size appears to go through the levee, at an unknown depth. Standpipe on the landside (LS). Provide a field description of this crossing. FS Date: 11/16/2020

Overview of levee

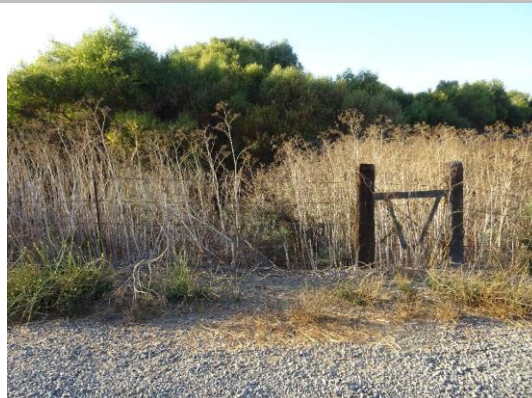
Photo 2 of 3 : UCIP\_SP\_2021\_62717\_91025.jpg

View waterward

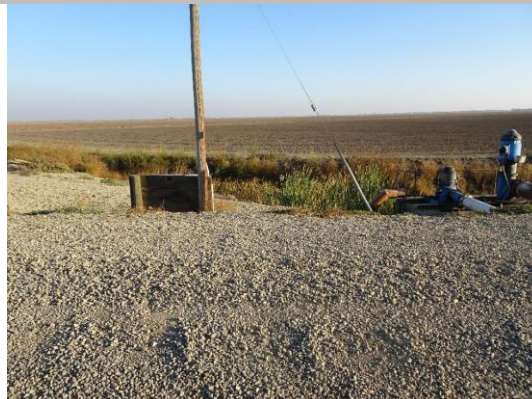
Photo 3 of 3 : UCIP\_SP\_2021\_62717\_91026.jpg

View landward

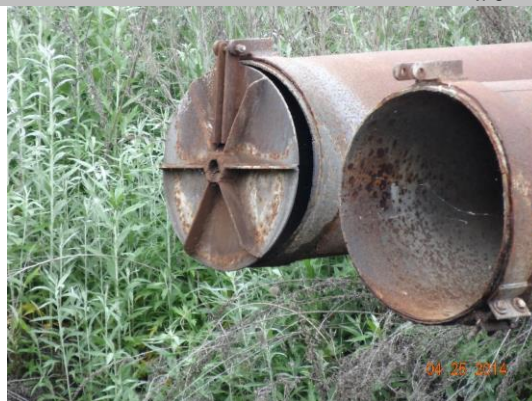
Photo 1 of 3 : UCIP\_SP\_2021\_62715\_71446.jpg

FS\_ID:62715  
 DS\_ID:24873  
 EP\_NO: N/A  
 Repair Type: Non-Urgent  
 Crossing Status: Found  
 UCIP Comments: 11/16/2020 Pipe status is still Non-Urgent. Dense vegetation and fence at WS inhibited proper inspection. No permit was found authorizing this encroachment. CVFPB will need to review crossing to determine owner. Pipe was field discovered - no DMP internal inspection has been done. (B. Singh - GEI, O. Magana - DWR UCIP)04/25/2014 Dense vegetation limits the inspector's visibility to identify signs of pipe failure (leaks) along the waterward slope. Recommend removing vegetation along pipe alignment to conduct proper inspection of structure. (DWR UCIP - O. Magana)  
 FIELD\_STRUCT\_DESC: 12-inch steel drainage discharge pipe sleeved through a 24-inch steel pipe through levee, at an unknown depth.  
 FS Date: 11/16/2020

Outlet visible on waterward side.

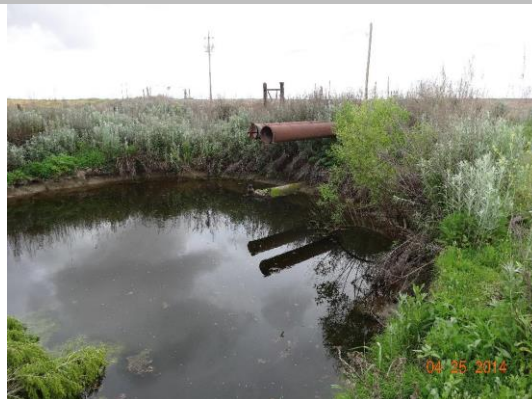
Photo 2 of 3 : UCIP\_SP\_2021\_62715\_71445.jpg

View of waterward side.

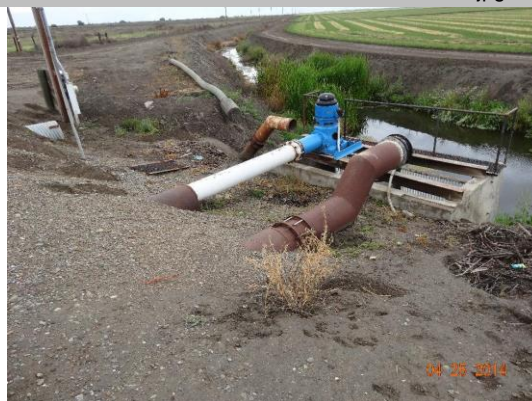
Photo 3 of 3 : UCIP\_SP\_2021\_62715\_71444.jpg

View of landward side.

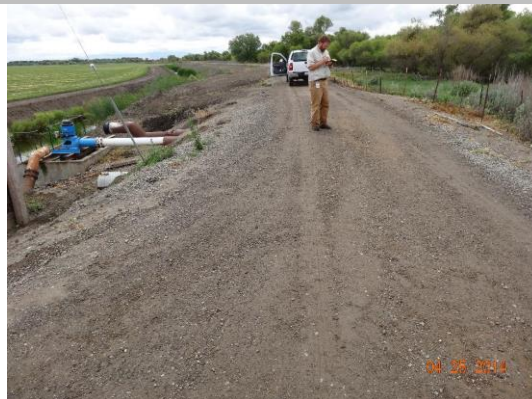
Photo 1 of 3 : UCIP\_SP\_2021\_62716\_66303.jpg

FS\_ID:62716  
DS\_ID:19599  
EP\_NO: N/A  
Repair Type: Non-Urgent  
Crossing Status: Found  
UCIP Comments: 11/16/2020 Pipe status is still Non-Urgent. Fence at WS inhibited proper inspection. CVFPB will need to review crossing to determine owner. DWR DMP has not completed an internal inspection of the pipe. (B. Singh - GEI, O. Magana - DWR UCIP)7/19/2016 same as previous inspection. crossing was downgraded from Urgent to Non-Urgent due to metal rod not interfering with flap gate. (O. Magana - DWR UCIP)4/25/2014 Unauthorized crossing through pipe. Line was pushed through existing crossing. Need to contact owner. Also sediment buildup in pipe visible from landward side--recommend clearing. (O. Magana - DWR UCIP)  
FIELD\_STRUCT\_DESC: 24-inch corrugated metal gravity drainage pipe through the levee, 5 feet below the crown. Flap gate on the waterside (WS) end. No permit for this crossing. [Additional Reference(s): DWR Levee Log, 2002 (HLM 20.27), listed as a 24-inch corrugated metal pipe (CMP)].

Overview of levee crown at crossing.

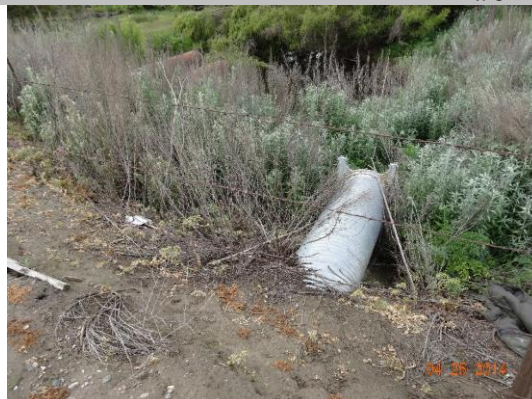
Photo 2 of 3 : UCIP\_SP\_2021\_62716\_66304.jpg

View of WS.

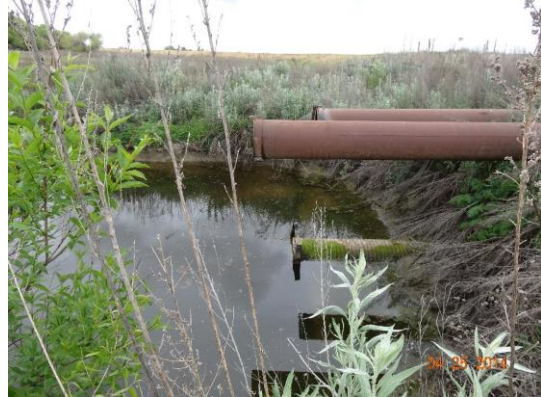
Photo 2 of 3 : UCIP\_SP\_2021\_61905\_66309.jpg

Multiple crossings visible on waterward side--36 inch CMP is submersed in water.

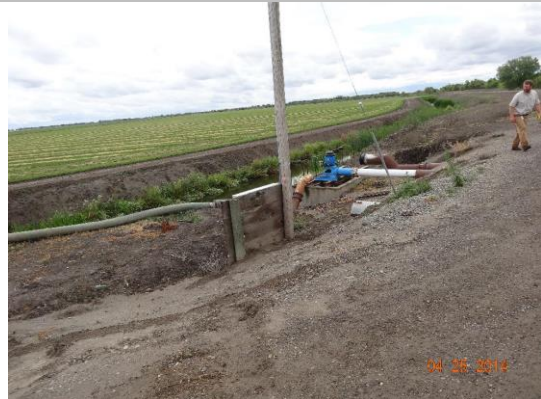
Photo 3 of 3 : UCIP\_SP\_2021\_61905\_66307.jpg

View of landward side.

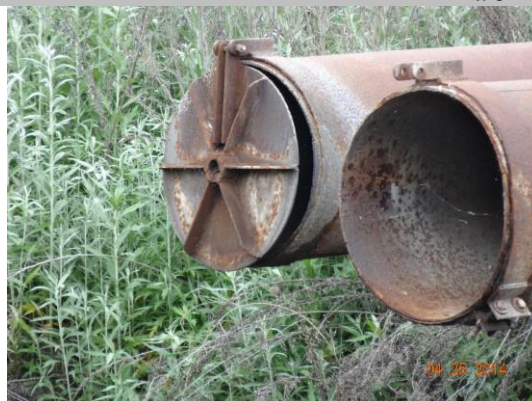
Photo 1 of 3 : UCIP\_SP\_2021\_61906\_71442.jpg

LM Start	20.27	Rating **	M	Issue No.	124
LM End	20.27	Issue Type +	En	Location *	
Category	Supplemental			GPS Latitude/Longitude	
				Start	End
Item	DWR UCIP Field Study			37.193542 °	37.193542 °
				-120.760300 °	-120.760300 °
DWR ID	24874				
Comment Code					
Inspector Comment					
FS_ID:61906 DS_ID:24874 EP_NO: N/A Repair Type: Non-Urgent Crossing Status: Found UCIP Comments: 04/25/2014 Dense vegetation limits the inspector's visibility to identify signs of pipe failure (leaks) along the waterward slope. Recommend removing vegetation along pipe alignment to conduct proper inspection of structure. (O. Magana - DWR UCIP) FIELD_STRUCT_DESC: 18-inch steel drainage discharge pipe sleeved through a 24-inch steel pipe through levee, at an unknown depth. FS Date: 4/25/2014

Outlets visible on waterward side.

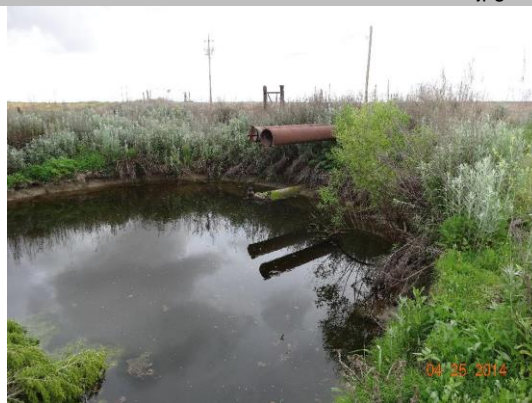
Photo 2 of 3 : UCIP\_SP\_2021\_61906\_71441.jpg

View of waterward side.

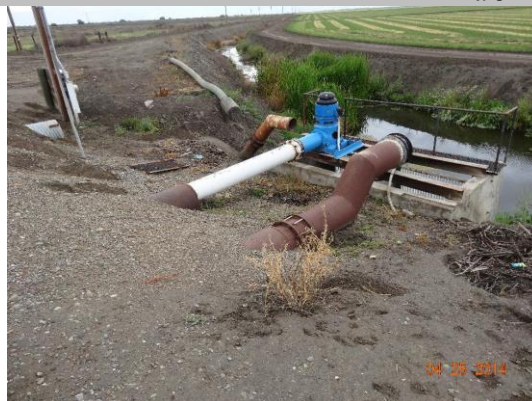
Photo 3 of 3 : UCIP\_SP\_2021\_61906\_71440.jpg

View of landward side.

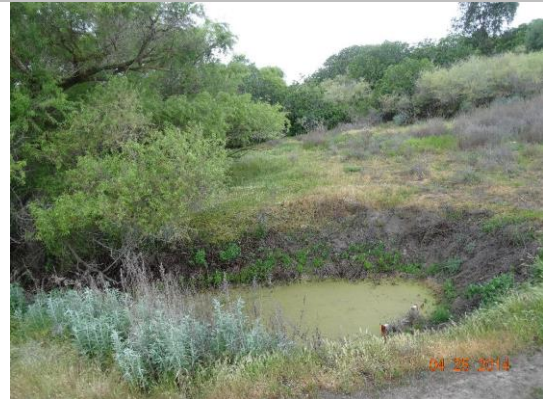
Photo 1 of 3 : UCIP\_SP\_2021\_61910\_66312.jpg

Comment Code					
Inspector Comment					
FS_ID:61910 DS_ID:19603 EP_NO: N/A Repair Type: Non-Urgent Crossing Status: Found UCIP Comments: 04/25/2014 Crossing is non-functional--crossing buried on landward side. Need to contact owner to determine status of crossing. If crossing is no longer used need to coordinate with CVFPB for proper abandonment. (O. Magana - DWR UCIP) FIELD_STRUCT_DESC: 36-inch corrugated metal gravity drainage pipe through the levee, 11.5 feet below the crown. Flap gate on the waterside (WS) end. Brass cap No. 40 bench mark (BM) on the headwall on the landside (LS). [Additional Reference(s): DWR Levee Log, 2002 (HLM 21.41), listed as a 36-inch corrugated metal pipe (CMP). USACE San Joaquin O&M Manual, Unit 601 Part 1 (SJR601.1), 1967, Revised 25 May 2011, (HLM 21.40), listed as a 36-inch CMP]. FS Date: 4/25/2014

View of waterward side.

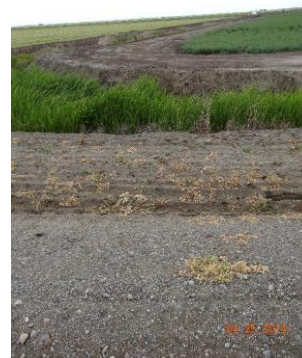
Photo 3 of 3 : UCIP\_SP\_2021\_61910\_66311.jpg

View of landward side.

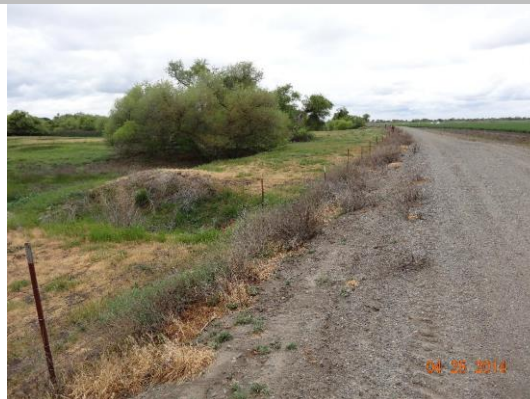
Photo 1 of 3 : UCIP\_SP\_2021\_61911\_65697.jpg

FS\_ID:61911  
DS\_ID:19604  
EP\_NO: N/A  
Repair Type: Non-Urgent  
Crossing Status: Found  
UCIP Comments: 04/25/2014 Non-functional crossing-landward side is buried. Need to contact owner to determine status of crossing. If crossing is no longer used need to coordinate with CVFPB for proper abandonment. (O. Magana - DWR UCIP)  
FIELD\_STRUCT\_DESC: 24-inch corrugated metal gravity drainage pipe through the levee, 9 feet below the crown. Flap gate on the waterside (WS) end. Brass cap No. 40 bench mark (BM) on the headwall on the landside (LS). [Additional Reference(s): DWR Levee Log, 2002 (HLM 21.78), listed as a 24-inch corrugated metal pipe (CMP). USACE San Joaquin O&M Manual, Unit 601 Part 1 (SJR601.1), 1967, Revised 25 May 2011, (HLM 21.76), listed as a 24-inch CMP].  
FS Date: 4/25/2014

View of waterward side.

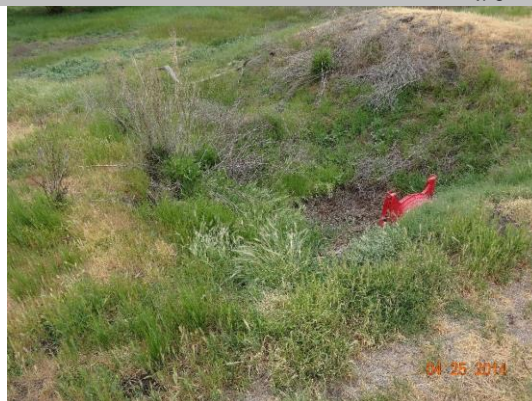
Photo 2 of 3 : UCIP\_SP\_2021\_61911\_65695.jpg

Flap gate visible on waterward side.

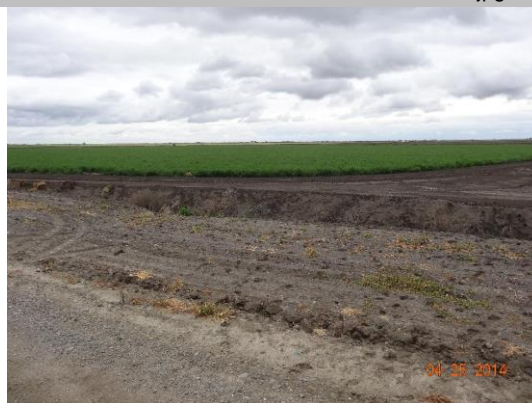
Photo 3 of 3 : UCIP\_SP\_2021\_61911\_65696.jpg

View of landward side.

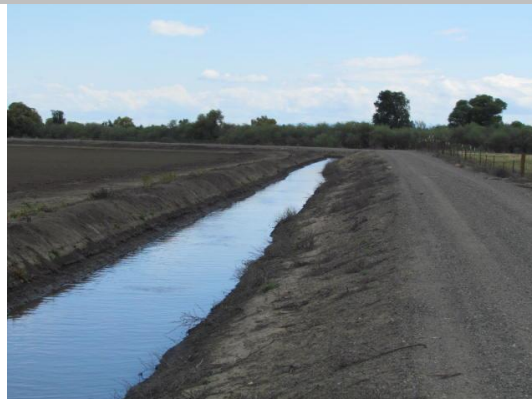
Photo 1 of 1 : SP\_2021\_NA0010\_118\_22\_20210308\_00005.jpg

LM Start	22.06	Rating **	U	Issue No.	22
LM End	22.52	Issue Type +	En	Location *	LS
Category	Earthen Levee			GPS Latitude/Longitude	
				Start	End
Item	Encroachments			37.172074 °	37.166906 °
				-120.754628 °	-120.749962 °
DWR ID	DWR_NA0010_01_s_2020_22				
Comment Code					
DT : Ditch					
Inspector Comment					
Ditch has encroached into landside toe and slope.

Looking upstream at irrigation at landside toe.

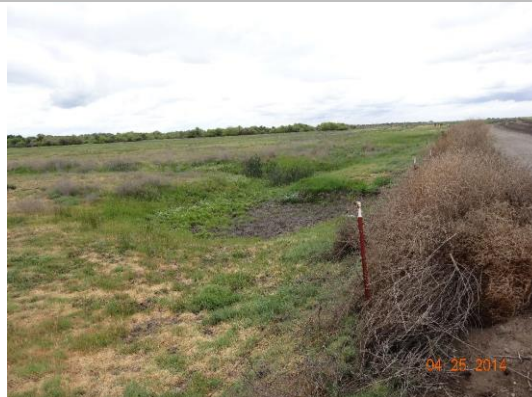
Photo 1 of 3 : UCIP\_SP\_2021\_61912\_65709.jpg

Comment Code					
Inspector Comment					
FS_ID:61912 DS_ID:19605 EP_NO: N/A Repair Type: Non-Urgent Crossing Status: Found UCIP Comments: 04/25/2014 Non-functional crossing--landward side is buried. Need to contact owner to determine status. If crossing is no longer used need to coordinate with CVFPB for proper abandonment. (O. Magana - DWR UCIP) FIELD_STRUCT_DESC: 24-inch corrugated metal gravity drainage pipe through the levee, 9 feet below the crown. Flap gate on the waterside (WS) end. Wooden headboards on the landside (LS) end. Brass cap No. 31 bench mark (BM) on the headwall on the LS. [Additional Reference(s): DWR Levee Log, 2002 (HLM 22.13), listed as a 24-inch corrugated metal pipe (CMP). USACE San Joaquin O&M Manual, Unit 601 Part 1 (SJR601.1), 1967, Revised 25 May 2011, (HLM 22.13), listed as a 24-inch CMP]. FS Date: 4/25/2014

View of waterward side.

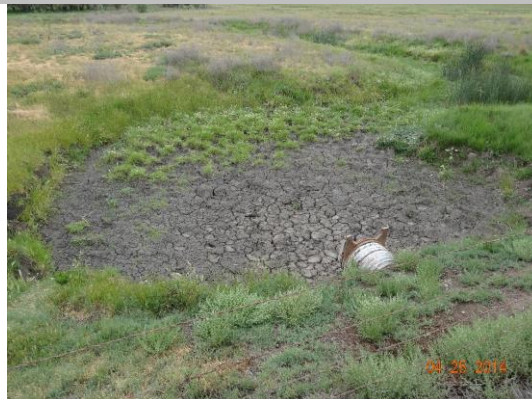
Photo 2 of 3 : UCIP\_SP\_2021\_61912\_65707.jpg

Flap gate visible on waterward side.

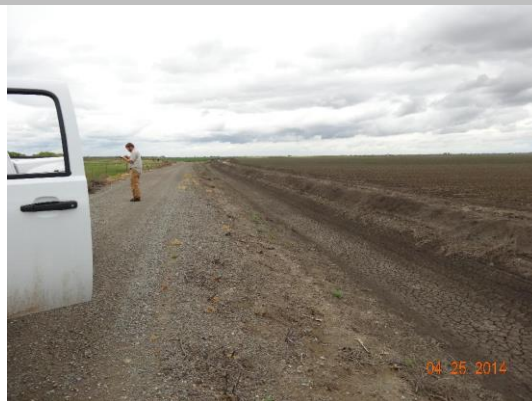
Photo 3 of 3 : UCIP\_SP\_2021\_61912\_65708.jpg

View of landward side.

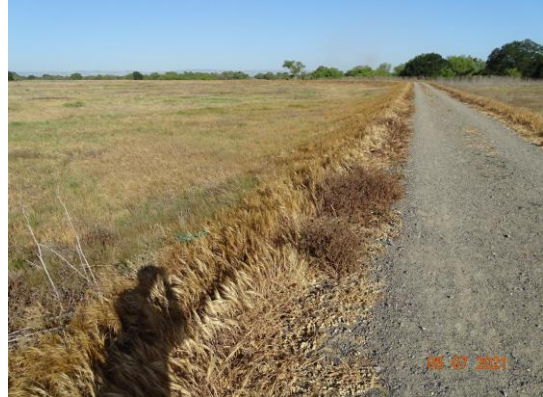
Photo 1 of 1 : SP\_2021\_NA0010\_119\_24\_20210517\_00065.jpg

LM Start	0.01	Rating **	M	Issue No.	24
LM End	3.57	Issue Type +	Ma	Location *	LS
Category	Earthen Levee			GPS Latitude/Longitude	
				Start	End
Item	Vegetation			37.296263 °	37.278144 °
				-120.880413 °	-120.840598 °
DWR ID	DWR_NA0010_02A_s_2021_24				
Comment Code					
V1 : Control annual grass and weeds on the levee slopes and easements.					
Inspector Comment

View of the landside slope looking downstream. (Spring 2021)

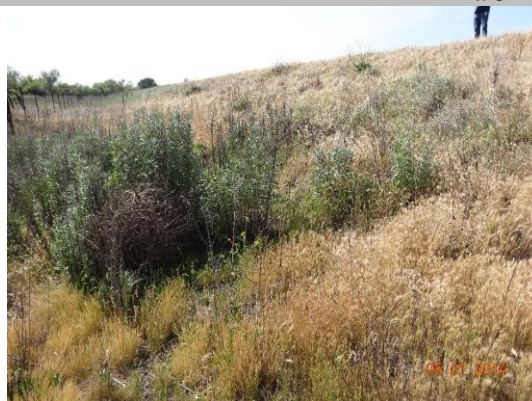
Photo 1 of 3 : UCIP\_SP\_2021\_61974\_66102.jpg

FS\_ID:61974  
DS\_ID:19652  
EP\_NO: N/A  
Repair Type: Non-Urgent  
Crossing Status: Found  
UCIP Comments: 05/01/2014 Dense vegetation limits the inspector's visibility to identify signs of pipe failure (leaks) along the slope. Recommend removing vegetation along pipe alignment to conduct proper inspection of structure. (O. Magana - DWR UCIP)  
FIELD\_STRUCT\_DESC: 24-inch corrugated metal gravity drainage pipe through the levee, 11 feet below the crown. Flap gate on the waterside (WS) end. Brass cap No. 139 bench mark (BM) on the headwall on the landside (LS). [Additional Reference(s): DWR Levee Log, 2002 (HLM 0.24), listed as a 24-inch corrugated metal pipe (CMP). USACE San Joaquin O&M Manual, Unit 601 Part 1 (SJR 601.1), 1967, Revised 25 May 2011, (HLM 0.24), listed as a 24-inch CMP].  
FS Date: 5/1/2014

View of waterward side.

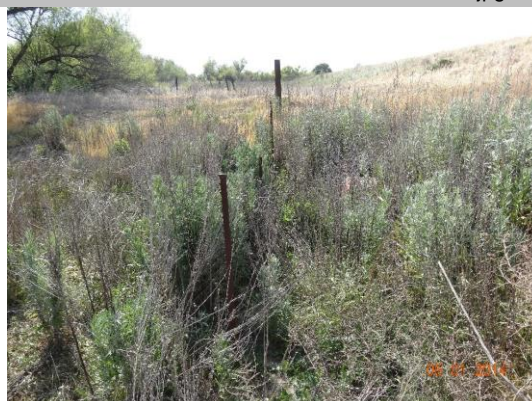
Photo 2 of 3 : UCIP\_SP\_2021\_61974\_66101.jpg

Fence along waterward side. No headwall was found on waterward side.

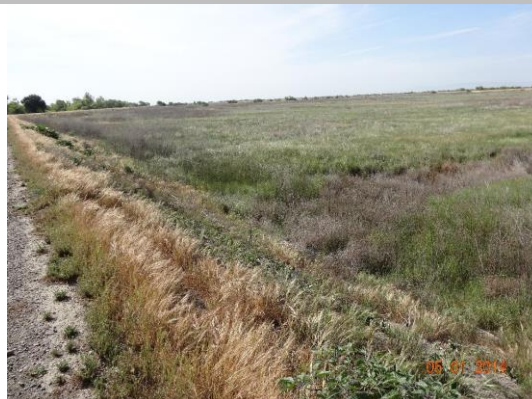
Photo 3 of 3 : UCIP\_SP\_2021\_61974\_66100.jpg

View of landward side.

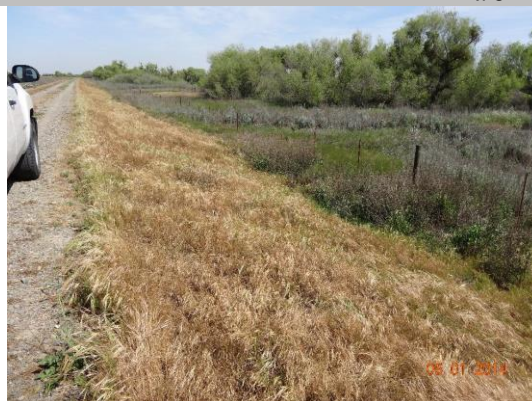
Photo 1 of 3 : UCIP\_SP\_2021\_61976\_66106.jpg

FS\_ID:61976  
 DS\_ID:19653  
 EP\_NO: N/A  
 Repair Type: Non-Urgent  
 Crossing Status: Found  
 UCIP Comments: 05/01/2014 Dense vegetation limits the inspector's visibility to identify signs of pipe failure (leaks) along the slope. Recommend removing vegetation along pipe alignment to conduct proper inspection of structure. (O. Magana - DWR UCIP)  
 FIELD\_STRUCT\_DESC: 24-inch corrugated metal gravity drainage pipe through the levee, 14.8 feet below the crown. Flap gate on the waterside (WS) end. Brass cap No. 138 bench mark (BM) on the headwall on the landside (LS). [Additional Reference(s): DWR Levee Log, 2002 (HLM 0.69), listed as a 24-inch corrugated metal pipe (CMP). USACE San Joaquin O&M Manual, Unit 601 Part 1 (SJR 601.1), 1967, Revised 25 May 2011, (HLM 0.67), listed as a 24-inch CMP].  
 FS Date: 5/1/2014

View of waterward side.

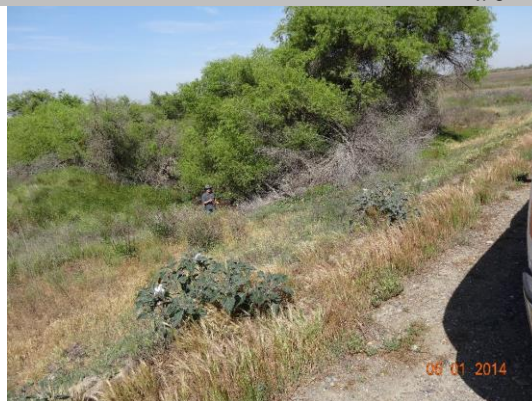
Photo 2 of 3 : UCIP\_SP\_2021\_61976\_66105.jpg

View of landward side.

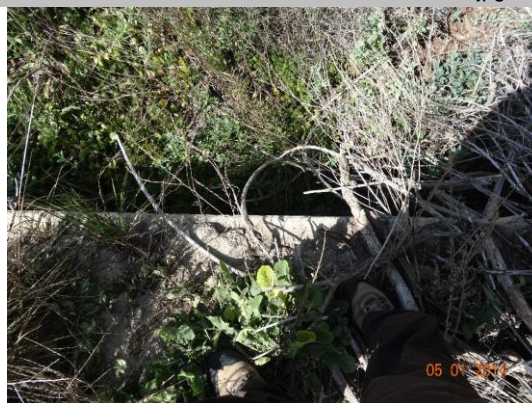
Photo 3 of 3 : UCIP\_SP\_2021\_61976\_66104.jpg

Concrete headwall found on landward side.

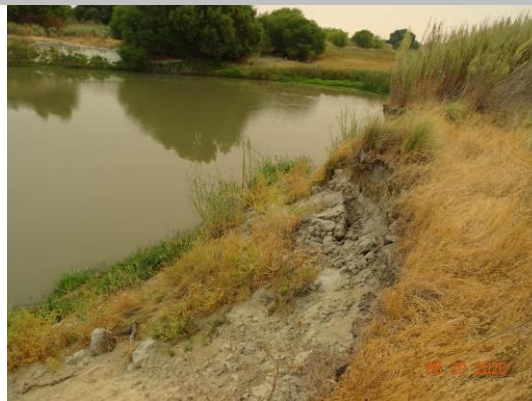
Photo 1 of 3 : SP\_2021\_NA0010\_119\_1\_20210308\_00001.jpg

LM Start	0.68	Rating **	U	Issue No.	1
LM End	0.75	Issue Type +	Ma	Location *	WS
Category	Supplemental			GPS Latitude/Longitude	
				Start	End
Item	DWR Erosion Survey			37.287517 °	37.287517 °
				-120.874583 °	-120.874583 °
DWR ID	NA0010U02ARM129.22				
Comment Code					
Inspector Comment					
Site ID: NA0010U02ARM129.22 08/20/2020: This site was discovered during the DWR Spring 2012 Levee Inspections. A 250-ft long levee section has completely eroded away and no longer provides adequate flood protection. Note: Unit 2A is in the process of being turned over to State Parks.

8/20/2020: View of the upstream end of the erosion looking upstream.

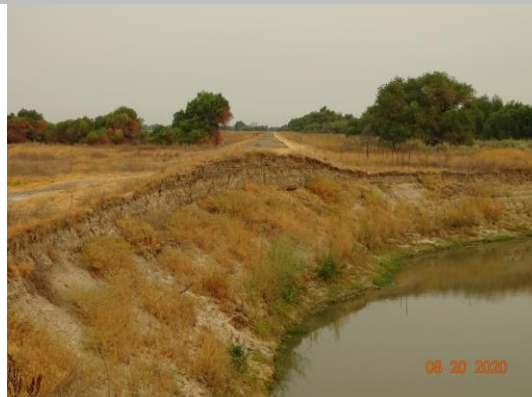
Photo 2 of 3 : SP\_2021\_NA0010\_119\_1\_20210308\_00002.jpg

8/20/2020: View of the eroded levee section looking downstream.

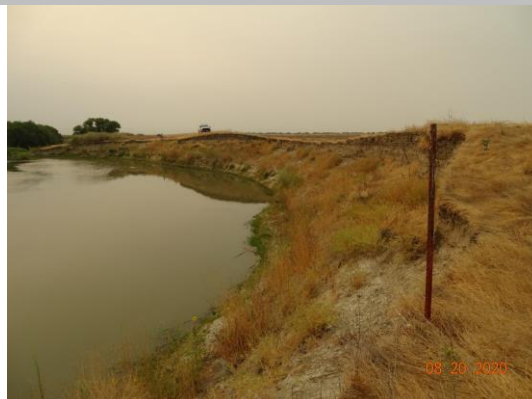
Photo 3 of 3 : SP\_2021\_NA0010\_119\_1\_20210308\_00003.jpg

8/20/2020: View of the eroded levee section looking upstream.

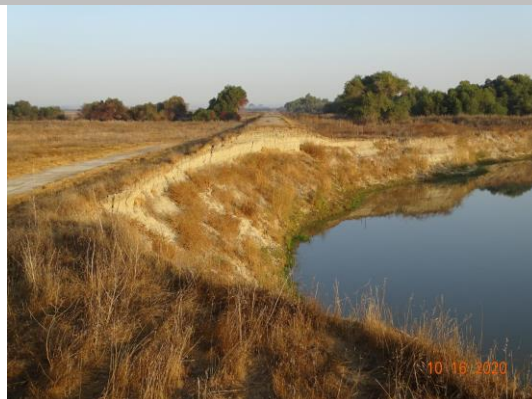
Photo 1 of 1 : SP\_2021\_NA0010\_119\_5\_20210308\_00005.jpg

LM Start	0.75	Rating **	U	Issue No.	5
LM End	0.78	Issue Type +	Ma	Location *	WS
Category	Earthen Levee			GPS Latitude/Longitude	
				Start	End
Item	Erosion / Bank Caving			37.287517 °	37.286543 °
				-120.874583 °	-120.873935 °
DWR ID	DWR_NA0010_02A_s_2012_5				
Comment Code					
E2 : Schedule repair of erosion site prior to the next inspection.					
Inspector Comment					
This section of the levee unit is in the process of being turned over to State Parks.

Looking downstream at erosion through the waterside slope and crown.  
(Fall 2020)

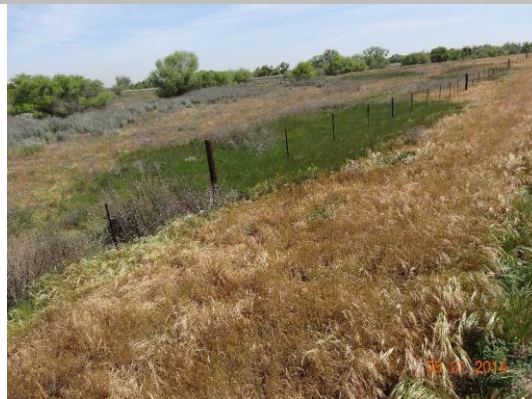
Photo 1 of 3 : UCIP\_SP\_2021\_61977\_66113.jpg

FS\_ID:61977  
DS\_ID:19654  
EP\_NO: N/A  
Repair Type: Non-Urgent  
Crossing Status: Found  
UCIP Comments: 05/01/2014 Dense vegetation limits the inspector's visibility to identify signs of pipe failure (leaks) along the slope. Recommend removing vegetation along pipe alignment to conduct proper inspection of structure. Sediment buildup in pipe recommend clearing. (O. Magana - DWR UCIP)  
FIELD\_STRUCT\_DESC: 24-inch corrugated metal gravity drainage pipe through the levee, 8.6 feet below the crown. Flap gate on the waterside (WS) end. Brass cap No. 137 bench mark (BM) on the headwall on the landside (LS). [Additional Reference(s): DWR Levee Log, 2002 (HLM 1.03), listed as a 24-inch corrugated metal pipe (CMP). USACE San Joaquin O&M Manual, Unit 601 Part 1 (SJR 601.1), 1967, Revised 25 May 2011, (HLM 1.02), listed as a 24-inch CMP].  
FS Date: 5/1/2014

View of waterward side.

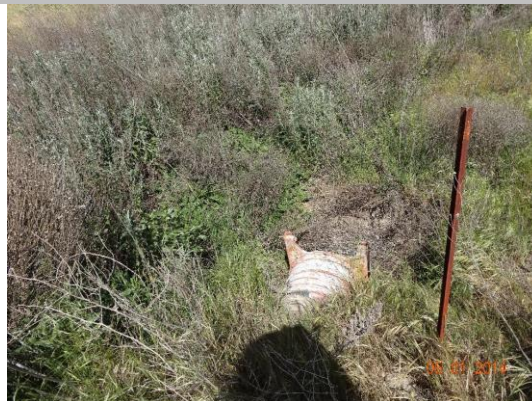
Photo 2 of 3 : UCIP\_SP\_2021\_61977\_66112.jpg

Pipe visible on waterward side.

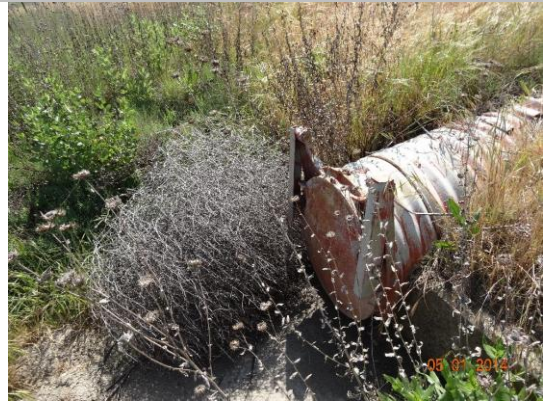
Photo 2 of 3 : UCIP\_SP\_2021\_61979\_66117.jpg

Flap gate visible on waterward side.

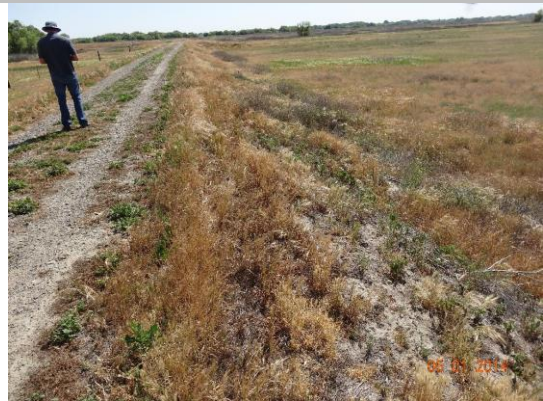
Photo 3 of 3 : UCIP\_SP\_2021\_61979\_66116.jpg

LM Start	<b>1.21</b>	Rating **	M	Issue No.	<b>7 (cont)</b>
LM End	<b>1.21</b>	Issue Type +	Ma	Location *

View of landward side.

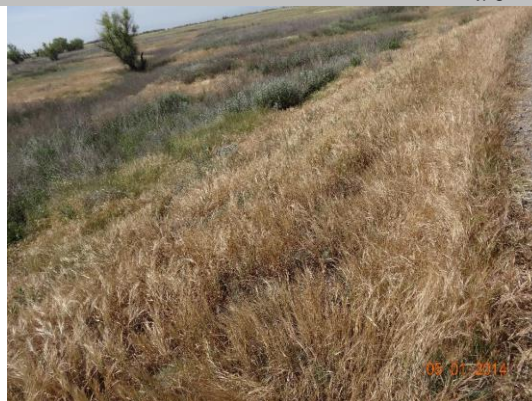
Photo 1 of 3 : UCIP\_SP\_2021\_62000\_66120.jpg

FS\_ID:62000  
DS\_ID:19656  
EP\_NO: N/A  
Repair Type: Non-Urgent  
Crossing Status: Found  
UCIP Comments: 05/01/2014 Dense vegetation limits the inspector's visibility to identify signs of pipe failure (leaks) along the slope. Recommend removing vegetation along pipe alignment to conduct proper inspection of structure. (O. Magana - DWR UCIP)  
FIELD\_STRUCT\_DESC: 36-inch corrugated metal gravity drainage pipe through the levee, 14.6 feet below the crown. Flap gate on the waterside (WS) end. Brass cap No. 135 bench mark (BM) on the headwall on the landside (LS). [Additional Reference(s): DWR Levee Log, 2002 (HLM 1.36), listed as a 36-inch corrugated metal pipe (CMP). USACE San Joaquin O&M Manual, Unit 601 Part 1 (SJR 601.1), 1967, Revised 25 May 2011, (HLM 1.34), listed as a 36-inch CMP].  
FS Date: 5/1/2014

LM Start	<b>1.33</b>	Rating **	M	Issue No.	<b>8 (cont)</b>
LM End	<b>1.33</b>	Issue Type +	Ma	Location *

View of landward side.

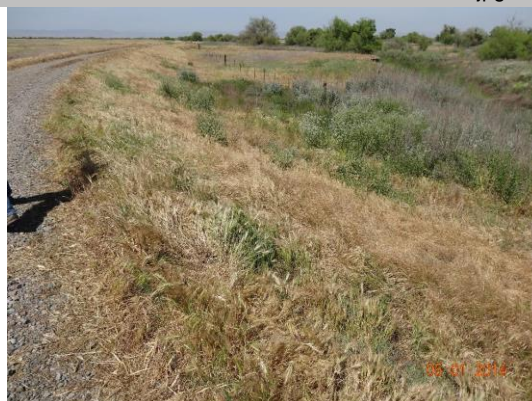
Photo 2 of 3 : UCIP\_SP\_2021\_62000\_66119.jpg

View of waterward side.

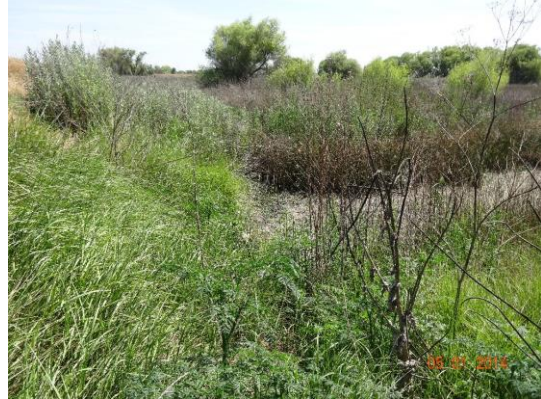
Photo 2 of 3 : UCIP\_SP\_2021\_61981\_66123.jpg

LM Start	1.61	Rating **	M	Issue No.	9 (cont)
LM End	1.61	Issue Type +	Ma	Location *	
Category	Supplemental			GPS Latitude/Longitude	
				Start	End
Item	DWR UCIP LMA Responsibility			37.288599 °	37.288599 °
				-120.862007 °	-120.862007 °
DWR ID	19657

Dense vegetation along levee slope and toe.

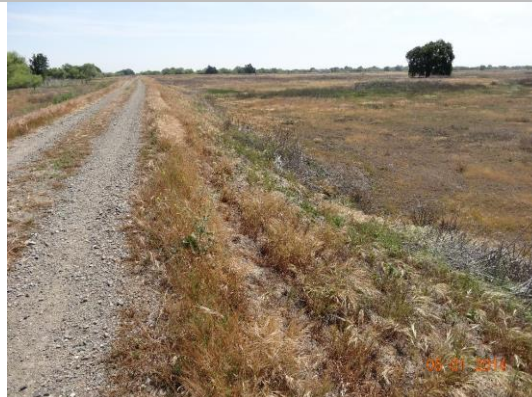
Photo 1 of 3 : UCIP\_SP\_2021\_61982\_66129.jpg

FS\_ID:61982  
DS\_ID:19658  
EP\_NO: N/A  
Repair Type: Non-Urgent  
Crossing Status: Found  
UCIP Comments: 05/01/2014 Dense vegetation limits the inspector's visibility to identify signs of pipe failure (leaks) along the slope. Recommend removing vegetation along pipe alignment to conduct proper inspection of structure. (O. Magana - DWR UCIP)  
FIELD\_STRUCT\_DESC: 24-inch corrugated metal gravity drainage pipe through the levee, 10.7 feet below the crown. Flap gate on the waterside (WS) end. Brass cap No. 135 bench mark (BM) on the headwall on the landside (LS). [Additional Reference(s): DWR Levee Log, 2002 (HLM 1.88), listed as a 24-inch corrugated metal pipe (CMP). USACE San Joaquin O&M Manual, Unit 601 Part 1 (SJR 601.1), 1967, Revised 25 May 2011, (HLM 1.86), listed as a 24-inch CMP].  
FS Date: 5/1/2014

LM Start	<b>1.85</b>	Rating **	M	Issue No.	<b>10 (cont)</b>
LM End	<b>1.85</b>	Issue Type +	Ma	Location *

View of landward side.

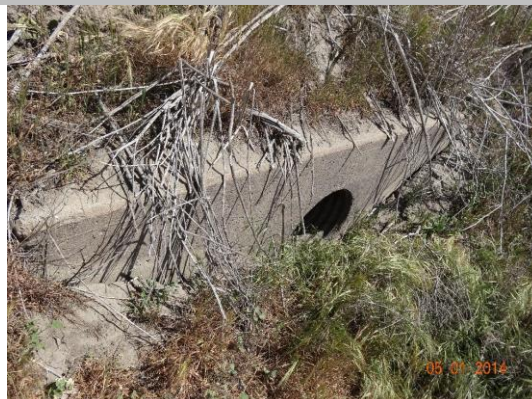
Photo 2 of 3 : UCIP\_SP\_2021\_61982\_66128.jpg

Concrete headwall visible on landward side.

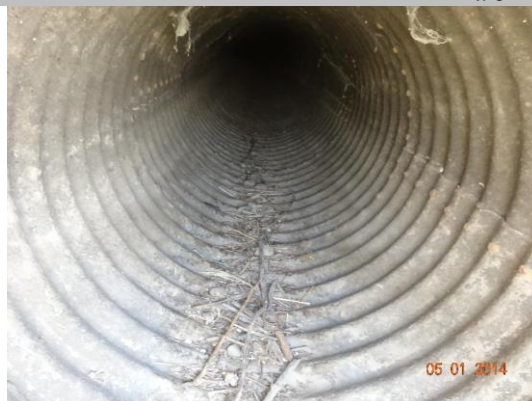
Photo 3 of 3 : UCIP\_SP\_2021\_61982\_66127.jpg

LM Start	<b>1.85</b>	Rating **	M	Issue No.	<b>10 (cont)</b>
LM End	<b>1.85</b>	Issue Type +	Ma	Location *	
Category	Supplemental		GPS Latitude/Longitude		
			Start	End	
Item	DWR UCIP LMA Responsibility		37.290836 °	37.290836 °	
			-120.858882 °	-120.858882 °	
DWR ID	19658

Inside view of pipe from landward side.

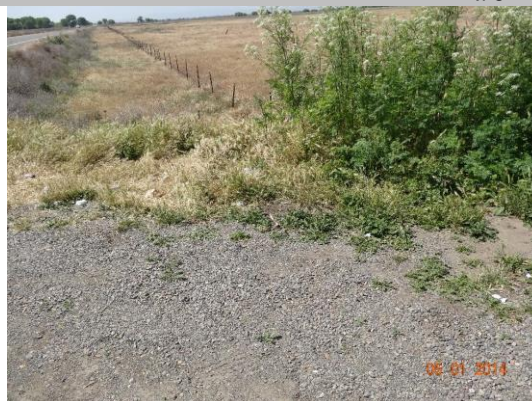
Photo 1 of 3 : UCIP\_SP\_2021\_61984\_66133.jpg

LM Start	<b>2.28</b>	Rating **	M	Issue No.	<b>11</b>
LM End	<b>2.28</b>	Issue Type +	Ma	Location *	
Category	Supplemental		GPS Latitude/Longitude		
			Start	End	
Item	DWR UCIP LMA Responsibility		37.291686 °	37.291686 °	
			-120.851475 °	-120.851475 °	
DWR ID	19659

FS\_ID:61984  
 DS\_ID:19659  
 EP\_NO: N/A  
 Repair Type: Non-Urgent  
 Crossing Status: Found  
 UCIP Comments: 05/01/2014 Dense vegetation limits the inspector's visibility to identify signs of pipe failure (leaks) along the slope. Recommend removing vegetation along pipe alignment to conduct proper inspection of structure. (O. Magana - DWR UCIP)  
 FIELD\_STRUCT\_DESC: 24-inch corrugated metal gravity drainage pipe through the levee, 7 feet below the crown. Flap gate on the waterside (WS) end. Brass cap No. 135 bench mark (BM) on the headwall on the landside (LS). [Additional Reference(s): DWR Levee Log, 2002 (HLM 2.32), listed as a 24-inch corrugated metal pipe (CMP). USACE San Joaquin O&M Manual, Unit 601 Part 1 (SJR 601.1), 1967, Revised 25 May 2011, (HLM 2.30), listed as a 24-inch CMP].  
 FS Date: 5/1/2014

View of landward side.

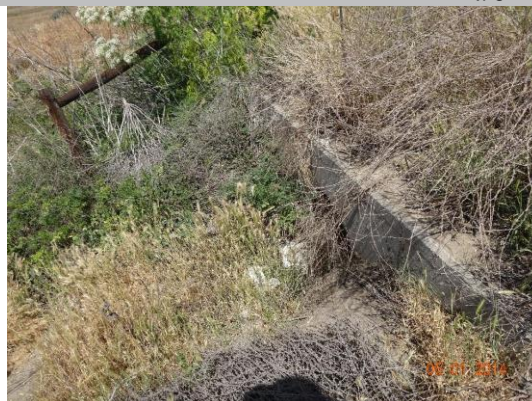
Photo 2 of 3 : UCIP\_SP\_2021\_61984\_66132.jpg

LM Start	<b>2.28</b>	Rating **	M	Issue No.	<b>11 (cont)</b>
LM End	<b>2.28</b>	Issue Type +	Ma	Location *	
Category	Supplemental		GPS Latitude/Longitude		
			Start	End	
Item	DWR UCIP LMA Responsibility		37.291686 °	37.291686 °	
			-120.851475 °	-120.851475 °	
DWR ID	19659

Concrete headwall visible on landward side.

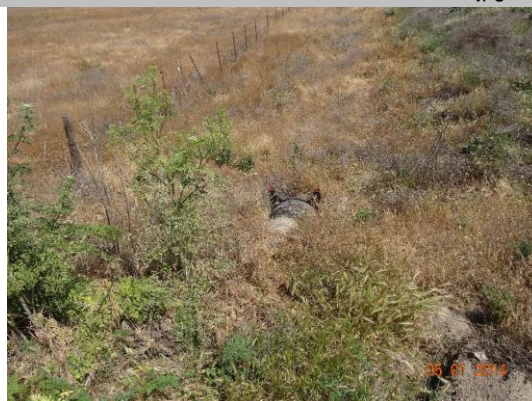
Photo 3 of 3 : UCIP\_SP\_2021\_61984\_66131.jpg

LM Start	<b>2.28</b>	Rating **	M	Issue No.	<b>11 (cont)</b>
LM End	<b>2.28</b>	Issue Type +	Ma	Location *

View of pipe through levee visible on waterward side.
