# Flood Control Project Maintenance Levee Inspections LMA District Cover Sheet

## Lower San Joaquin Levee District

**Flood Control Project Maintenance  
Levee Inspections  
Unit Cover Sheet**

Waterway			Bank	Unit Miles
Unit No. 01 San Joaquin River			Right	22.52
	Spring (March - May)	Summer (June - August)	(September - November) Fall	Winter (December - February)
Unit Maintenance Rating (Fall Only)				
Date of Inspection	5/4/2021 - 5/4/2021			
DWR Inspector	Corey Fujitani			
Accompanied By

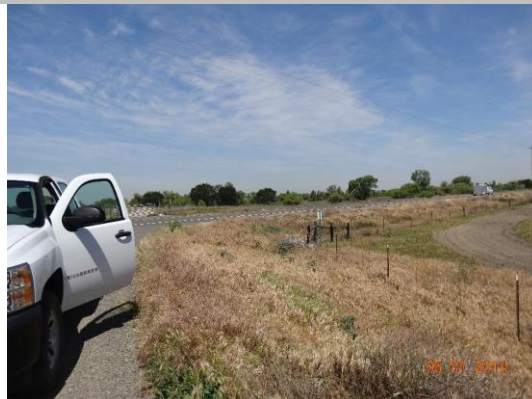
Photo 1 of 3 : UCIP\_SP\_2021\_61985\_66137.jpg

FS\_ID:61985  
DS\_ID:19660  
EP\_NO: N/A  
Repair Type: Non-Urgent  
Crossing Status: Found  
UCIP Comments: 05/01/2014 Dense vegetation limits the inspector's visibility to identify signs of pipe failure (leaks) along the slope. Recommend removing vegetation along pipe alignment to conduct proper inspection of structure. (O. Magana - DWR UCIP)  
FIELD\_STRUCT\_DESC: 24-inch corrugated metal gravity drainage pipe through the levee, 7 feet below the crown. Flap gate on the waterside (WS) end. Brass cap No. 135 bench mark (BM) on the headwall on the landside (LS). [Additional Reference(s): DWR Levee Log, 2002 (HLM 2.34), listed as a 24-inch corrugated metal pipe (CMP). USACE San Joaquin O&M Manual, Unit 601 Part 1 (SJR 601.1), 1967, Revised 25 May 2011, (HLM 2.32), listed as a 24-inch CMP].  
FS Date: 5/1/2014

LM Start	<b>2.30</b>	Rating **	M	Issue No.	<b>12 (cont)</b>
LM End	<b>2.30</b>	Issue Type +	Ma	Location *

View of waterward side.

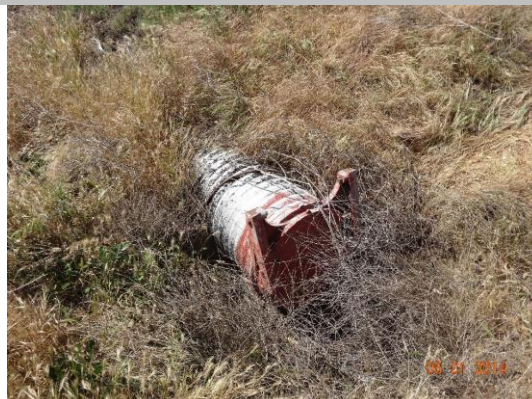
Photo 2 of 3 : UCIP\_SP\_2021\_61985\_66136.jpg

Flap gate visible on waterward side.

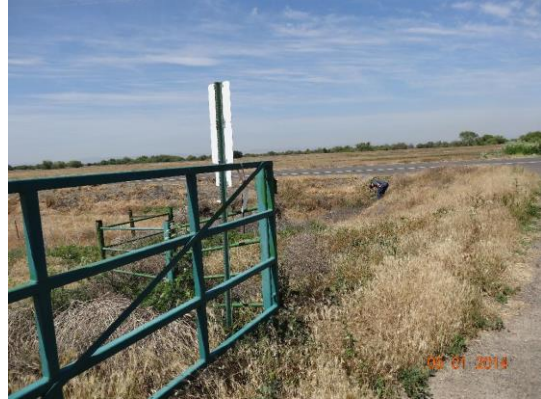
Photo 3 of 3 : UCIP\_SP\_2021\_61985\_66138.jpg

LM Start	2.30	Rating **	M	Issue No.	12 (cont)
LM End	2.30	Issue Type +	Ma	Location *	
Category	Supplemental			GPS Latitude/Longitude	
				Start	End
Item	DWR UCIP LMA Responsibility			37.291532 °	37.291532 °
				-120.851203 °	-120.851203 °
DWR ID	19660

Overview of landward slope.

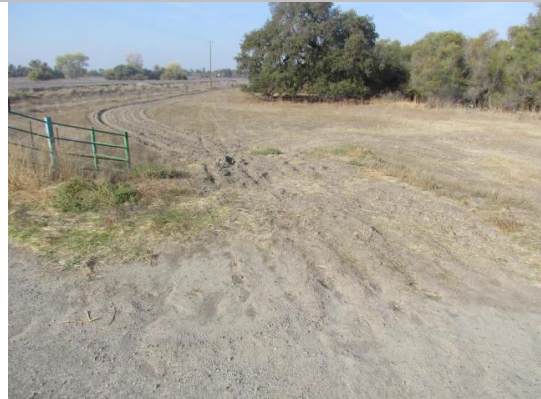
Photo 1 of 1 : SP\_2021\_NA0010\_119\_2\_20210308\_00004.jpg

LM Start	2.32	Rating **	M	Issue No.	2
LM End	2.32	Issue Type +	En	Location *	LS
Category	Earthen Levee			GPS Latitude/Longitude	
				Start	End
Item	Encroachments			37.291433 °	37.291433 °
				-120.850917 °	-120.850917 °
DWR ID	DWR_NA0010_02A_s_2012_2				
Comment Code					
RA : Ramp					
Inspector Comment					
Unauthorized ramps are located on the landside and waterside slopes.

Looking northeast at unauthorized ramp on landward slope.

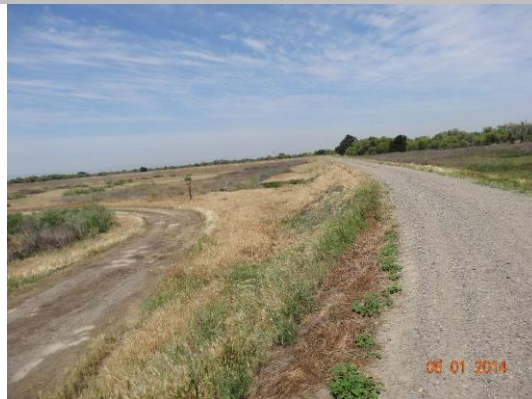
Photo 1 of 3 : UCIP\_SP\_2021\_61986\_66142.jpg

FS\_ID:61986  
DS\_ID:19661  
EP\_NO: N/A  
Repair Type: Non-Urgent  
Crossing Status: Found  
UCIP Comments: 05/01/2014 Dense vegetation limits the inspector's visibility to identify signs of pipe failure (leaks) along the slope. Recommend removing vegetation along pipe alignment to conduct proper inspection of structure. (O. Magana - DWR UCIP)  
FIELD\_STRUCT\_DESC: 24-inch corrugated metal gravity drainage pipe through the levee, 10 feet below the crown. Flap gate on the waterside (WS) end. Brass cap No. 130 bench mark (BM) on the headwall on the landside (LS). [Additional Reference(s): DWR Levee Log, 2002 (HLM 2.60), listed as a 24-inch corrugated metal pipe (CMP). USACE San Joaquin O&M Manual, Unit 601 Part 1 (SJR 601.1), 1967, Revised 25 May 2011, (HLM 2.59), listed as a 24-inch CMP].  
FS Date: 5/1/2014

LM Start	<b>2.58</b>	Rating **	M	Issue No.	<b>13 (cont)</b>
LM End	<b>2.58</b>	Issue Type +	Ma	Location *

View of landward side.

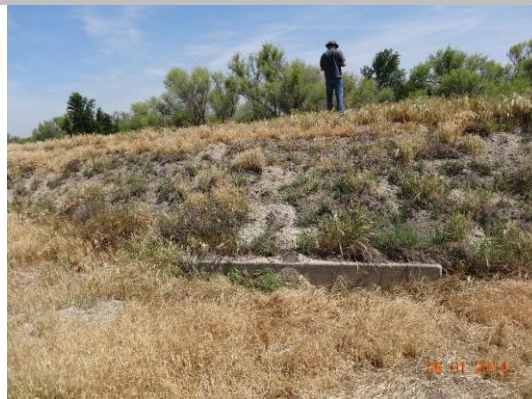
Photo 2 of 3 : UCIP\_SP\_2021\_61986\_66141.jpg

Concrete headwall visible on landward side.

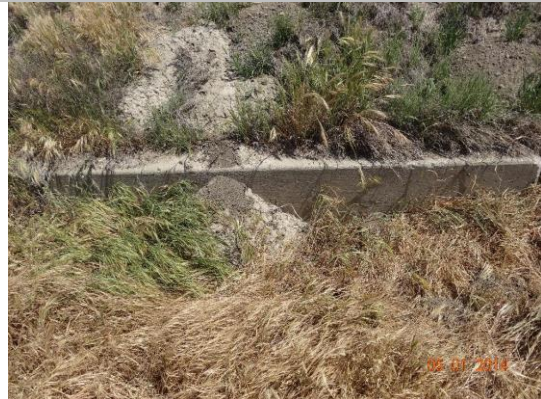
Photo 3 of 3 : UCIP\_SP\_2021\_61986\_66140.jpg

LM Start	<b>2.58</b>	Rating **	M	Issue No.	<b>13 (cont)</b>
LM End	<b>2.58</b>	Issue Type +	Ma	Location *	
Category	Supplemental		GPS Latitude/Longitude		
			Start	End	
Item	DWR UCIP LMA Responsibility		37.289487 °	37.289487 °	
			-120.846941 °	-120.846941 °	
DWR ID	19661

Non-functional crossing concrete headwall and inlet buried on landward side.

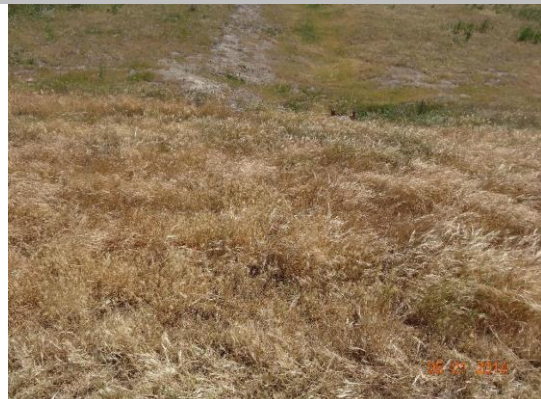
Photo 1 of 3 : UCIP\_SP\_2021\_61987\_66145.jpg

LM Start	<b>2.95</b>	Rating **	M	Issue No.	<b>14</b>
LM End	<b>2.95</b>	Issue Type +	Ma	Location *	
Category	Supplemental		GPS Latitude/Longitude		
			Start	End	
Item	DWR UCIP LMA Responsibility		37.284326 °	37.284326 °	
			-120.845157 °	-120.845157 °	
DWR ID	19662

FS\_ID:61987  
DS\_ID:19662  
EP\_NO: N/A  
Repair Type: Non-Urgent  
Crossing Status: Found  
UCIP Comments: 05/01/2014 Dense vegetation limits the inspector's visibility to identify signs of pipe failure (leaks) along the slope. Recommend removing vegetation along pipe alignment to conduct proper inspection of structure. (O. Magana - DWR UCIP)  
FIELD\_STRUCT\_DESC: 24-inch corrugated metal gravity drainage pipe through the levee, 10 feet below the crown. Flap gate on the waterside (WS) end. Brass cap No. 130 bench mark (BM) on the headwall on the landside (LS). [Additional Reference(s): DWR Levee Log, 2002 (HLM 2.97), listed as a 24-inch corrugated metal pipe (CMP). USACE San Joaquin O&M Manual, Unit 601 Part 1 (SJR 601.1), 1967, Revised 25 May 2011, (HLM 2.96), listed as a 24-inch CMP].  
FS Date: 5/1/2014

View of waterward side.

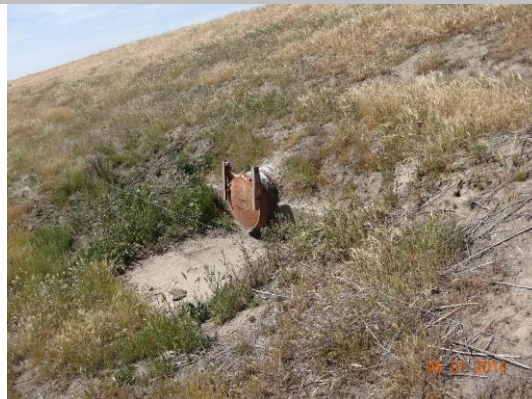
Photo 2 of 3 : UCIP\_SP\_2021\_61987\_66144.jpg

LM Start	2.95	Rating **	M	Issue No.	14 (cont)
LM End	2.95	Issue Type +	Ma	Location *	
Category	Supplemental			GPS Latitude/Longitude	
				Start	End
Item	DWR UCIP LMA Responsibility			37.284326 °	37.284326 °
				-120.845157 °	-120.845157 °
DWR ID	19662

Flap gate visible on waterward side.

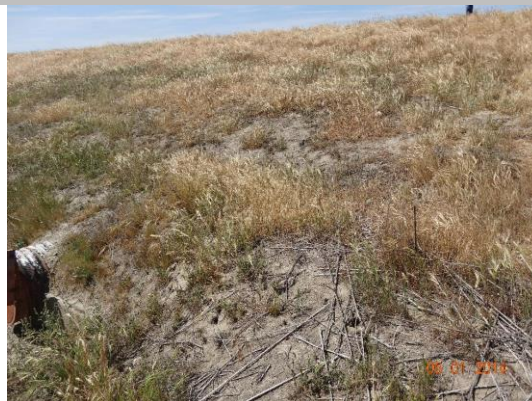
Photo 3 of 3 : UCIP\_SP\_2021\_61987\_66149.jpg

LM Start	<b>2.95</b>	Rating **	M	Issue No.	<b>14 (cont)</b>
LM End	<b>2.95</b>	Issue Type +	Ma	Location *

View of slope on waterward side.

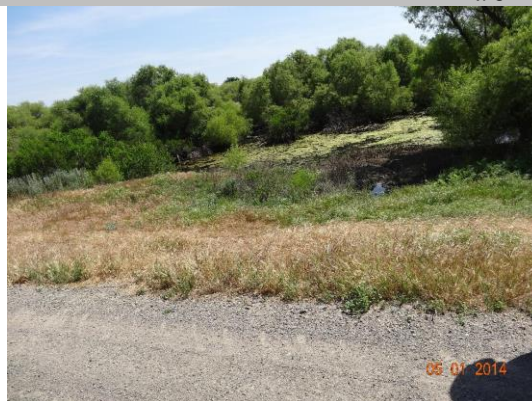
Photo 1 of 3 : UCIP\_SP\_2021\_61988\_66151.jpg

FS\_ID:61988  
DS\_ID:19665  
EP\_NO: N/A  
Repair Type: Non-Urgent  
Crossing Status: Found  
UCIP Comments: 05/01/2014 Dense vegetation limits the inspector's visibility to identify signs of pipe failure (leaks) along the slope. Recommend removing vegetation along pipe alignment to conduct proper inspection of structure. (O. Magana - DWR UCIP)  
FIELD\_STRUCT\_DESC: 24-inch corrugated metal gravity drainage pipe through the levee, 12.4 feet below the crown. Flap gate on the waterside (WS) end. Brass cap No. 130 bench mark (BM) on the headwall on the landside (LS). [Additional Reference(s): DWR Levee Log, 2002 (HLM 3.31), listed as a 24-inch corrugated metal pipe (CMP). USACE San Joaquin O&M Manual, Unit 601 Part 1 (SJR 601.1), 1967, Revised 25 May 2011, (HLM 3.29), listed as a 24-inch CMP].  
FS Date: 5/1/2014

LM Start	<b>3.28</b>	Rating **	M	Issue No.	<b>15 (cont)</b>
LM End	<b>3.28</b>	Issue Type +	Ma	Location *

View of waterward side.

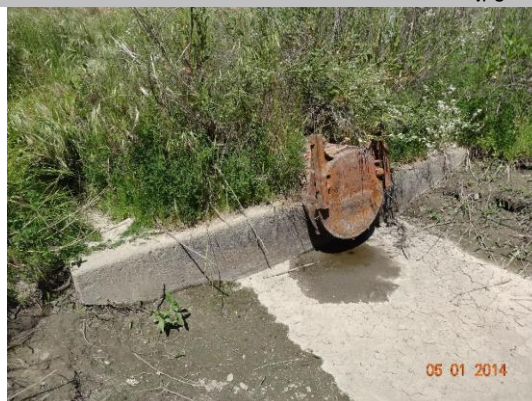
Photo 2 of 3 : UCIP\_SP\_2021\_61988\_66153.jpg

Flap gate visible on waterward side.

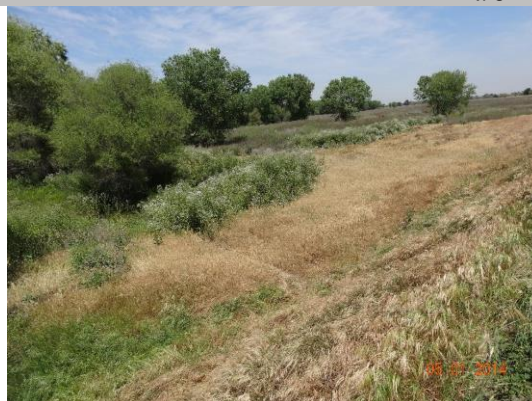
Photo 3 of 3 : UCIP\_SP\_2021\_61988\_66152.jpg

LM Start	<b>3.28</b>	Rating **	M	Issue No.	<b>15 (cont)</b>
LM End	<b>3.28</b>	Issue Type +	Ma	Location *	
Category	Supplemental		GPS Latitude/Longitude		
			Start	End	
Item	DWR UCIP LMA Responsibility		37.279656 °	37.279656 °	
			-120.844795 °	-120.844795 °	
DWR ID	19665

View of landward side.

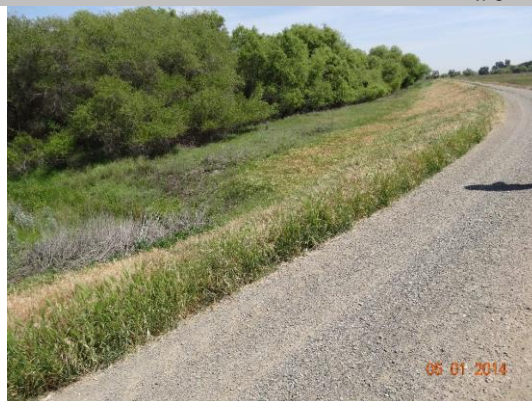
Photo 1 of 3 : UCIP\_SP\_2021\_61989\_66155.jpg

LM Start	<b>3.61</b>	Rating **	M	Issue No.	<b>16</b>
LM End	<b>3.61</b>	Issue Type +	Ma	Location *	
Category	Supplemental		GPS Latitude/Longitude		
			Start	End	
Item	DWR UCIP LMA Responsibility		37.278203 °	37.278203 °	
			-120.839884 °	-120.839884 °	
DWR ID	19666

FS\_ID:61989  
 DS\_ID:19666  
 EP\_NO: N/A  
 Repair Type: Non-Urgent  
 Crossing Status: Found  
 UCIP Comments: 05/01/2014 Dense vegetation limits the inspector's visibility to identify signs of pipe failure (leaks) along the slope. Recommend removing vegetation along pipe alignment to conduct proper inspection of structure. (O. Magana - DWR UCIP)  
 FIELD\_STRUCT\_DESC: 24-inch corrugated metal gravity drainage pipe through the levee, 10 feet below the crown. Flap gate on the waterside (WS) end. Brass cap No. 130 bench mark (BM) on the headwall on the landside (LS). [Additional Reference(s): DWR Levee Log, 2002 (HLM 3.63), listed as a 24-inch corrugated metal pipe (CMP). USACE San Joaquin O&M Manual, Unit 601 Part 1 (SJR 601.1), 1967, Revised 25 May 2011, (HLM 3.62), listed as a 24-inch CMP].  
 FS Date: 5/1/2014

View of waterward side.

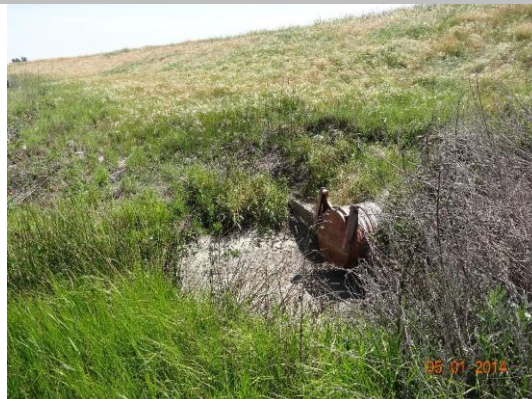
Photo 2 of 3 : UCIP\_SP\_2021\_61989\_66154.jpg

LM Start	<b>3.61</b>	Rating **	M	Issue No.	<b>16 (cont)</b>
LM End	<b>3.61</b>	Issue Type +	Ma	Location *	
Category	Supplemental		GPS Latitude/Longitude		
			Start	End	
Item	DWR UCIP LMA Responsibility		37.278203 °	37.278203 °	
			-120.839884 °	-120.839884 °	
DWR ID	19666

Flap gate visible on waterward side.

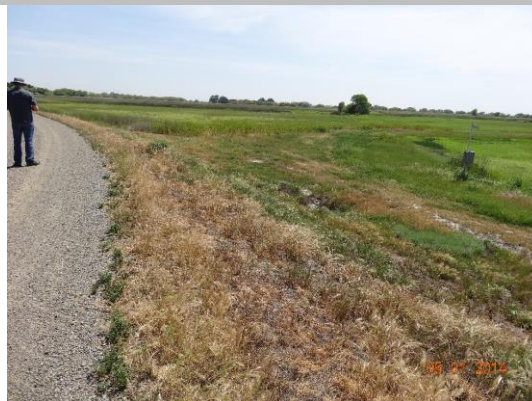
Photo 3 of 3 : UCIP\_SP\_2021\_61989\_66156.jpg

LM Start	<b>3.61</b>	Rating **	M	Issue No.	<b>16 (cont)</b>
LM End	<b>3.61</b>	Issue Type +	Ma	Location *

View of landward side.

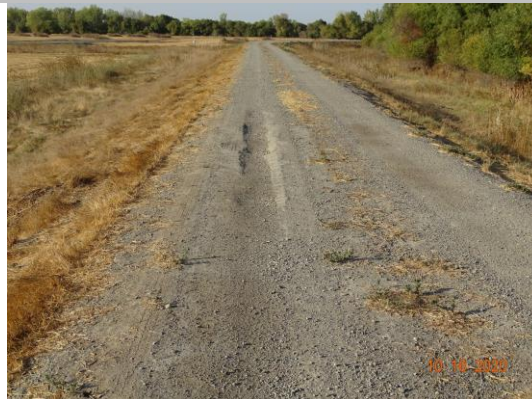
Photo 1 of 1 : SP\_2021\_NA0010\_119\_23\_20210308\_00006.jpg

LM Start	3.69	Rating **	A/W	Issue No.	23
LM End	3.69	Issue Type +	Ma	Location *	CR
Category	Earthen Levee			GPS Latitude/Longitude	
				Start	End
Item	Crown Surface / Depressions / Rutting			37.278949 °	37.278949 °
				-120.838776 °	-120.838776 °
DWR ID	DWR_NA0010_02A_f_2020_23				
Comment Code					
C2 : Repair depressions or ruts in the crown or slope.					
Inspector Comment

Rutting along the levee crown. (Fall 2020)

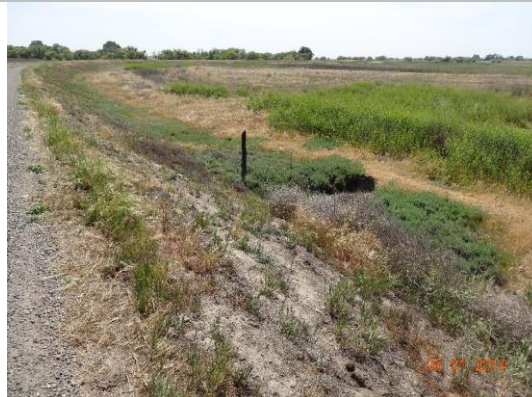
Photo 1 of 3 : UCIP\_SP\_2021\_61990\_66161.jpg

FS\_ID:61990  
DS\_ID:19667  
EP\_NO: N/A  
Repair Type: Non-Urgent  
Crossing Status: Found  
UCIP Comments: 05/01/2014 Signs of erosion or sink hole present on landward toe--Need to contact owner. Dense vegetation limits the inspector's visibility to identify signs of pipe failure (leaks) along the slope. Recommend removing vegetation along pipe alignment to conduct proper inspection of structure. (O. Magana - DWR UCIP)  
FIELD\_STRUCT\_DESC: 24-inch corrugated metal gravity drainage pipe through the levee, 8.6 feet below the crown. Flap gate on the waterside (WS) end. Brass cap No. 130 bench mark (BM) on the headwall on the landside (LS). [Additional Reference(s): DWR Levee Log, 2002 (HLM 3.96), listed as a 24-inch corrugated metal pipe (CMP). USACE San Joaquin O&M Manual, Unit 601 Part 1 (SJR 601.1), 1967, Revised 25 May 2011, (HLM 3.95), listed as a 24-inch CMP].  
FS Date: 5/1/2014

LM Start	<b>3.94</b>	Rating **	M	Issue No.	<b>17 (cont)</b>
LM End	<b>3.94</b>	Issue Type +	Ma	Location *

View of landward side.

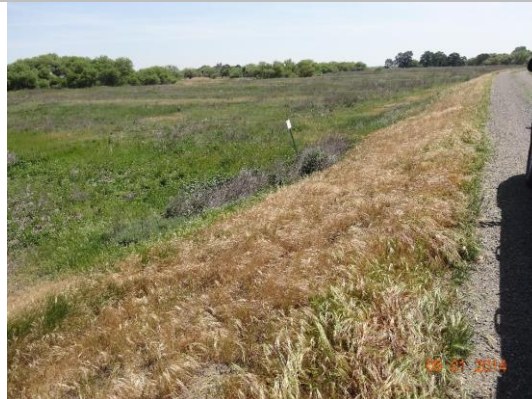
Photo 2 of 3 : UCIP\_SP\_2021\_61990\_66160.jpg

View of waterward side.

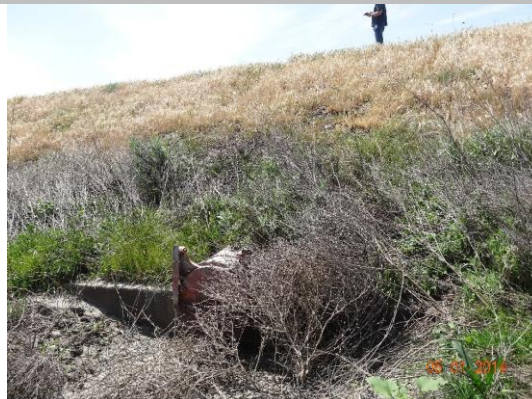
Photo 3 of 3 : UCIP\_SP\_2021\_61990\_66159.jpg

LM Start	<b>3.94</b>	Rating **	M	Issue No.	<b>17 (cont)</b>
LM End	<b>3.94</b>	Issue Type +	Ma	Location *	
Category	Supplemental		GPS Latitude/Longitude		
			Start	End	
Item	DWR UCIP LMA Responsibility		37.279704 °	37.279704 °	
			-120.834709 °	-120.834709 °	
DWR ID	19667

Flap gate and concrete headwall visible through dense vegetation.

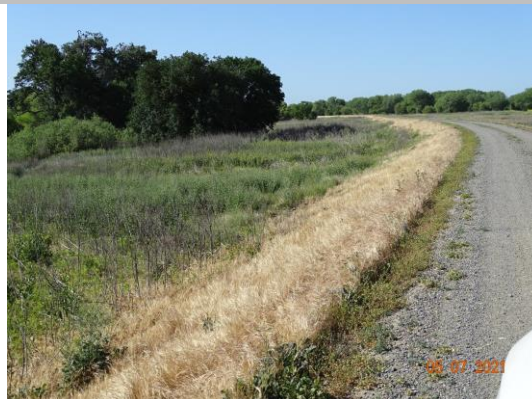
Photo 1 of 1 : SP\_2021\_NA0010\_119\_26\_20210517\_00067.jpg

LM Start	4.15	Rating **	M	Issue No.	26
LM End	7.84	Issue Type +	Ma	Location *	WS
Category	Earthen Levee			GPS Latitude/Longitude	
				Start	End
Item	Vegetation			37.277624 °	37.231535 °
				-120.832450 °	-120.812106 °
DWR ID	DWR_NA0010_02A_s_2021_26				
Comment Code					
V1 : Control annual grass and weeds on the levee slopes and easements.					
Inspector Comment

View of vegetation on the waterside slope. (Spring 2021)

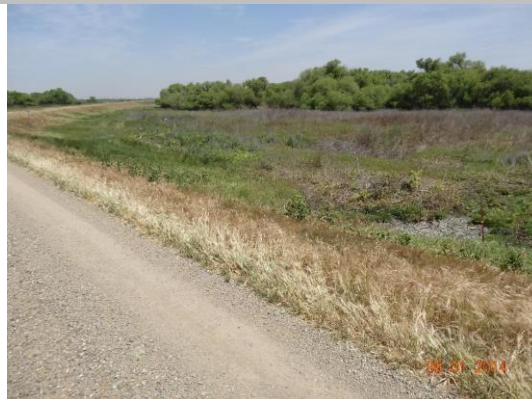
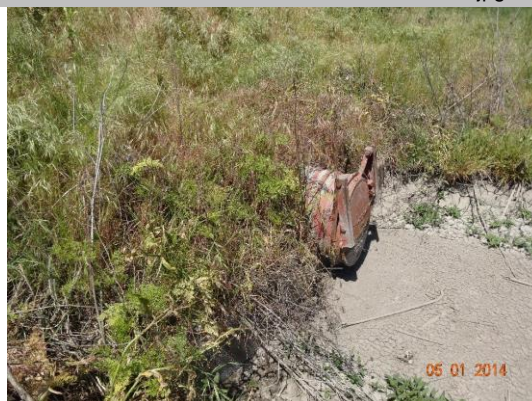
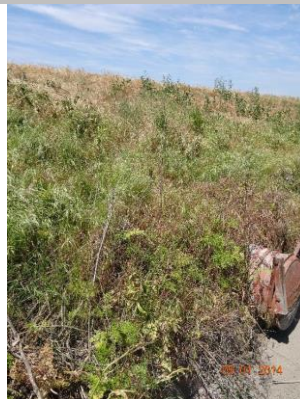
Photo 1 of 3 : UCIP\_SP\_2021\_61992\_66167.jpg

FS\_ID:61992  
DS\_ID:19668  
EP\_NO: N/A  
Repair Type: Non-Urgent  
Crossing Status: Found  
UCIP Comments: 05/01/2014 Dense vegetation limits the inspector's visibility to identify signs of pipe failure (leaks) along the slope. Recommend removing vegetation along pipe alignment to conduct proper inspection of structure. (O. Magana - DWR UCIP)  
FIELD\_STRUCT\_DESC: 24-inch corrugated metal gravity drainage pipe through the levee, 8 feet below the crown. Flap gate on the waterside (WS) end. Brass cap No. 125 bench mark (BM) on the headwall on the landside (LS). [Additional Reference(s): DWR Levee Log, 2002 (HLM 5.45), listed as a 24-inch corrugated metal pipe (CMP). USACE San Joaquin O&M Manual, Unit 601 Part 1 (SJR 601.1), 1967, Revised 25 May 2011, (HLM 5.43), listed as a 24-inch CMP].  
FS Date: 5/1/2014

View of waterward side.

Flap gate visible on waterward side.

View of waterward slope covered by vegetation.

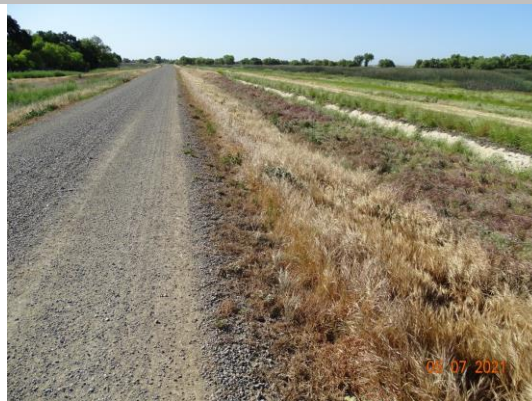
Photo 1 of 1 : SP\_2021\_NA0010\_119\_27\_20210517\_00068.jpg

LM Start	5.44	Rating **	M	Issue No.	27
LM End	7.85	Issue Type +	Ma	Location *	LS
Category	Earthen Levee			GPS Latitude/Longitude	
				Start	End
Item	Vegetation			37.259668 °	37.231492 °
				-120.831402 °	-120.812060 °
DWR ID	DWR_NA0010_02A_s_2021_27				
Comment Code					
V1 : Control annual grass and weeds on the levee slopes and easements.					
Inspector Comment

View of vegetation growing on the landside slope. (Spring 2021)

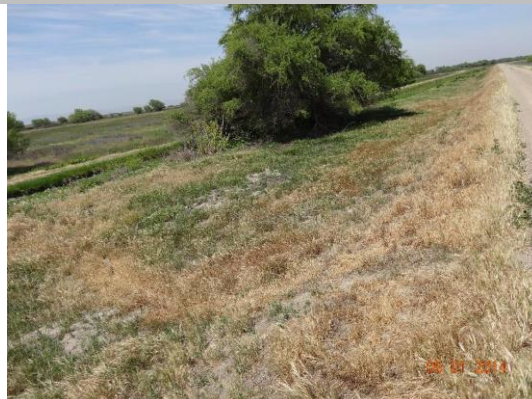
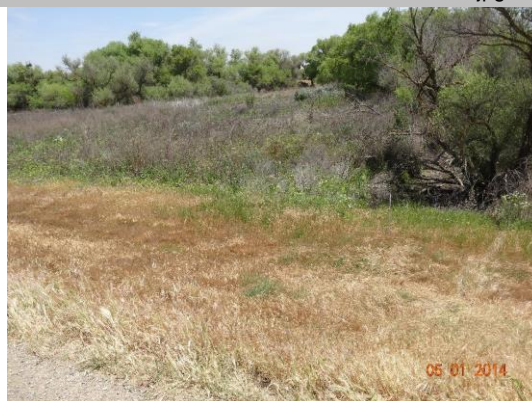
Photo 1 of 2 : UCIP\_SP\_2021\_61993\_66171.jpg

FS\_ID:61993  
DS\_ID:19669  
EP\_NO: N/A  
Repair Type: Non-Urgent  
Crossing Status: Found  
UCIP Comments: 05/01/2014 Dense vegetation limits the inspector's visibility to identify signs of pipe failure (leaks) along the slope. Recommend removing vegetation along pipe alignment to conduct proper inspection of structure. (O. Magana - DWR UCIP)  
FIELD\_STRUCT\_DESC: 24-inch corrugated metal gravity drainage pipe through the levee, 7.7 feet below the crown. Flap gate on the waterside (WS) end. Brass cap No. 125 bench mark (BM) on the headwall on the landside (LS). [Additional Reference(s): DWR Levee Log, 2002 (HLM 6.06), listed as a 24-inch corrugated metal pipe (CMP). USACE San Joaquin O&M Manual, Unit 601 Part 1 (SJR 601.1), 1967, Revised 25 May 2011, (HLM 6.06), listed as a 24-inch CMP].  
FS Date: 5/1/2014

View of landward side.

View of waterward side.

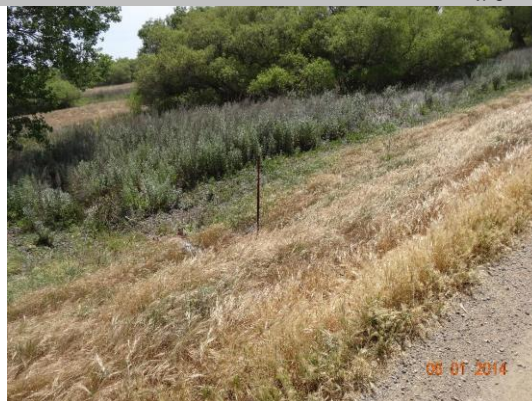
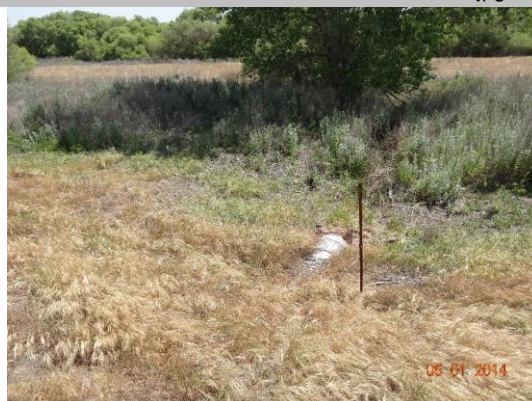
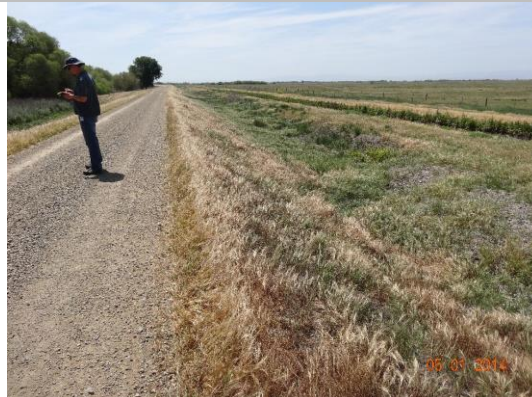
Photo 1 of 3 : UCIP\_SP\_2021\_61994\_66173.jpg

FS\_ID:61994  
DS\_ID:19670  
EP\_NO: N/A  
Repair Type: Non-Urgent  
Crossing Status: Found  
UCIP Comments: 05/01/2014 Dense vegetation limits the inspector's visibility to identify signs of pipe failure (leaks) along the slope. Recommend removing vegetation along pipe alignment to conduct proper inspection of structure. (O. Magana - DWR UCIP)  
FIELD\_STRUCT\_DESC: 24-inch corrugated metal gravity drainage pipe through the levee, 7.7 feet below the crown. Flap gate on the waterside (WS) end. Brass cap No. 125 bench mark (BM) on the headwall on the landside (LS). [Additional Reference(s): DWR Levee Log, 2002 (HLM 6.50), listed as a 24-inch corrugated metal pipe (CMP). USACE San Joaquin O&M Manual, Unit 601 Part 1 (SJR 601.1), 1967, Revised 25 May 2011, (HLM 6.50), listed as a 24-inch CMP].  
FS Date: 5/1/2014

View of waterward side.

Crossing and flap gate visible on waterward side.

Overview of levee crown and landward slope.

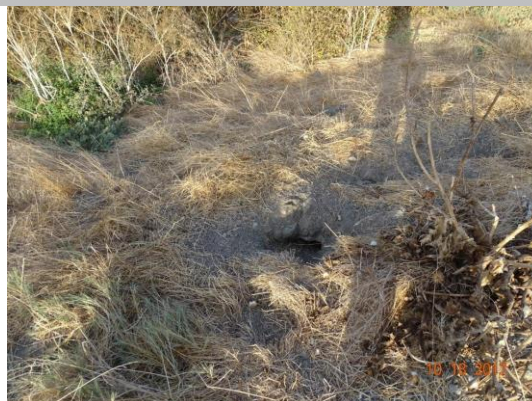
Photo 1 of 1 : SP\_2021\_NA0010\_119\_28\_20210308\_00008.jpg

LM Start	6.97	Rating **	A/W	Issue No.	28
LM End	6.97	Issue Type +	Ma	Location *	LS
Category	Earthen Levee			GPS Latitude/Longitude	
				Start	End
Item	Animal Control			37.241125 °	37.241125 °
				-120.821747 °	-120.821747 °
DWR ID	DWR_NA0010_02A_f_2017_28				
Comment Code					
A3 : No rodents visible, but rodent burrows visible; need to backfill and compact or grout burrows.					
Inspector Comment

Looking northwest at landside slope.

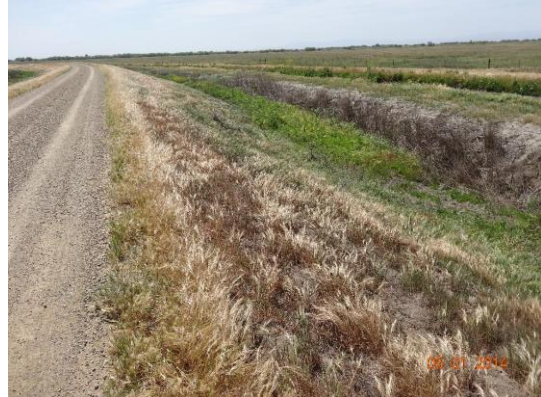
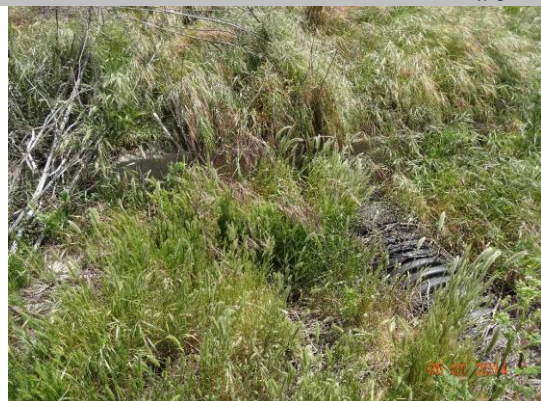
Photo 1 of 3 : UCIP\_SP\_2021\_61995\_66178.jpg

FS\_ID:61995  
DS\_ID:19671  
EP\_NO: N/A  
Repair Type: Non-Urgent  
Crossing Status: Found  
UCIP Comments: 05/01/2014 Dense vegetation limits the inspector's visibility to identify signs of pipe failure (leaks) along the slope. Recommend removing vegetation along pipe alignment to conduct proper inspection of structure. Pipe extension visible on landward side-- need to contact owner for additional information about extension/modification. (O. Magana - DWR UCIP)  
FIELD\_STRUCT\_DESC: 24-inch corrugated metal gravity drainage pipe through the levee, 12.6 feet below the crown. Flap gate on the waterside (WS) end. Brass cap No. 125 bench mark (BM) on the headwall on the landside (LS). [Additional Reference(s): DWR Levee Log, 2002 (HLM 7.06), listed as a 24-inch corrugated metal pipe (CMP). USACE San Joaquin O&M Manual, Unit 601 Part 1 (SJR 601.1), 1967, Revised 25 May 2011, (HLM 7.05), listed as a 24-inch CMP].

View of landward side.

Pipe extension visible on landward side attached to inlet at concrete headwall.

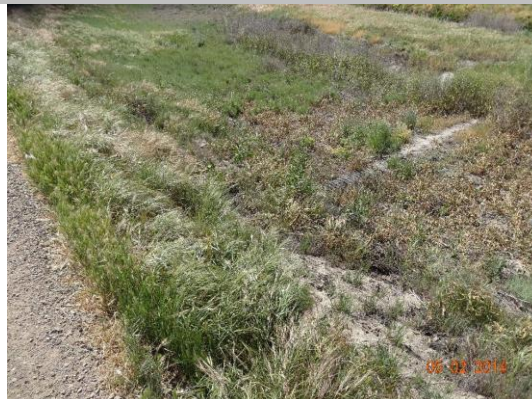
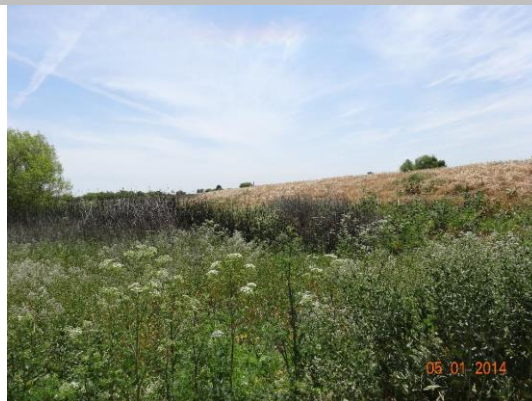
Photo 2 of 3 : UCIP\_SP\_2021\_61997\_66182.jpg

LM Start	7.74	Rating **	M	Issue No.	22 (cont)
LM End	7.74	Issue Type +	Ma	Location *	
Category	Supplemental			GPS Latitude/Longitude	
				Start	End
Item	DWR UCIP LMA Responsibility			37.232650 °	37.232650 °
				-120.813363 °	-120.813363 °
DWR ID	19673

View of landward side.

View of waterward side--photo taken from levee toe looking towards alignment of crossing.

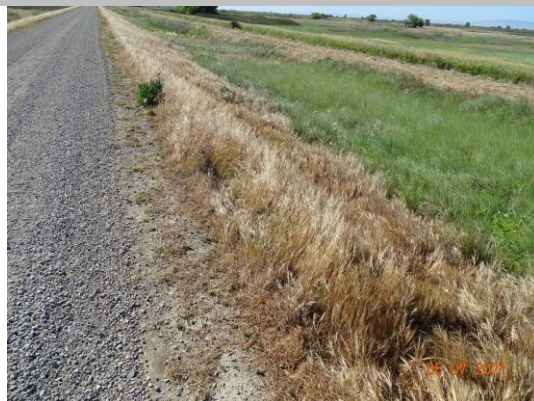
Photo 1 of 1 : SP\_2021\_NA0010\_120\_17\_20210517\_00041.jpg

LM Start	7.87	Rating **	M	Issue No.	17
LM End	9.66	Issue Type +	Ma	Location *	LS
Category	Earthen Levee			GPS Latitude/Longitude	
				Start	End
Item	Vegetation			37.231235 °	37.220367 °
				-120.811789 °	-120.784770 °
DWR ID	DWR_NA0010_02B_s_2021_17				
Comment Code					
V1 : Control annual grass and weeds on the levee slopes and easements.					
Inspector Comment

View of vegetation along the landside slope. (Spring 2021)

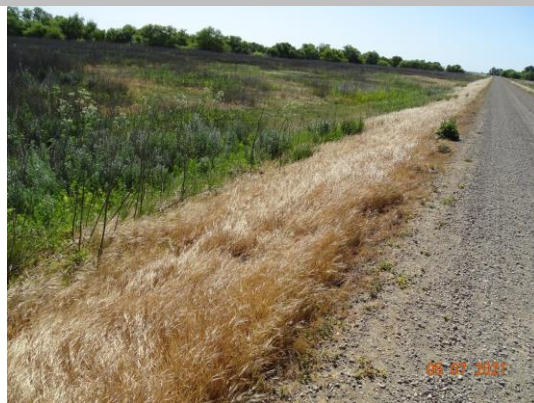
Photo 1 of 1 : SP\_2021\_NA0010\_120\_18\_20210517\_00042.jpg

LM Start	7.87	Rating **	M	Issue No.	18
LM End	12.49	Issue Type +	Ma	Location *	WS
Category	Earthen Levee			GPS Latitude/Longitude	
				Start	End
Item	Vegetation			37.231235 °	37.187663 °
				-120.811789 °	-120.766198 °
DWR ID	DWR_NA0010_02B_s_2021_18				
Comment Code					
V1 : Control annual grass and weeds on the levee slopes and easements.					
Inspector Comment

Looking upstream along the waterside slope. (Spring 2021)

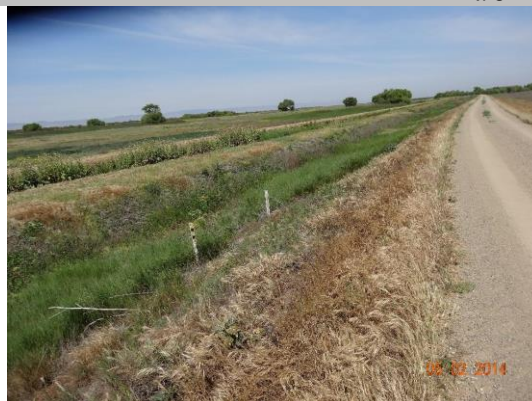
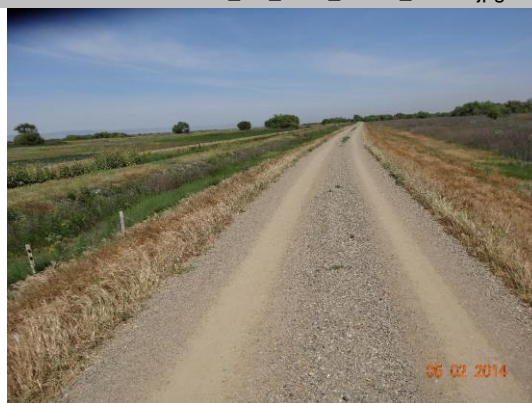
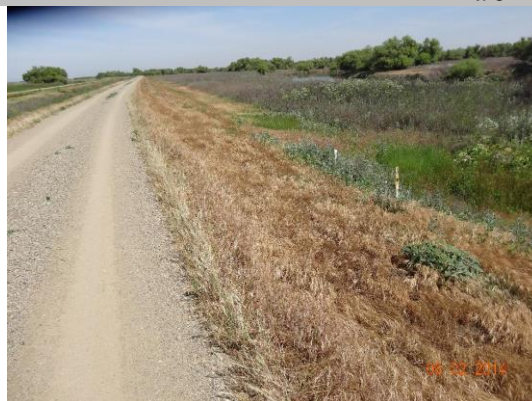
Photo 1 of 3 : UCIP\_SP\_2021\_62001\_66184.jpg

FS\_ID:62001  
DS\_ID:19674  
EP\_NO: N/A  
Repair Type: Non-Urgent  
Crossing Status: Found  
UCIP Comments: 05/14/2014 Dense vegetation limits the inspector's visibility to identify signs of pipe failure (leaks) along the slope and landward headwall. Recommend removing vegetation along pipe alignment and toe to conduct proper inspection of structure. Sediment buildup in pipe visible from landward side--recommend clearing. (O. Magana - DWR UCIP)  
FIELD\_STRUCT\_DESC: 24-inch corrugated metal gravity drainage pipe through the levee, 9 feet below the crown. Flap gate on the waterside (WS) end. Brass cap No. 120 bench mark (BM) on the headwall on the landside (LS). [Additional Reference(s): DWR Levee Log, 2002 (HLM 8.17), listed as a 24-inch corrugated metal pipe (CMP). USACE San Joaquin O&M Manual, Unit 601 Part 1 (SJR 601.1), 1967, Revised 25 May 2011, (HLM 8.16), listed as a 24-inch CMP].  
FS Date: 5/14/2014

View of landward side.

Overview of levee crown at crossing.

View of waterward side.

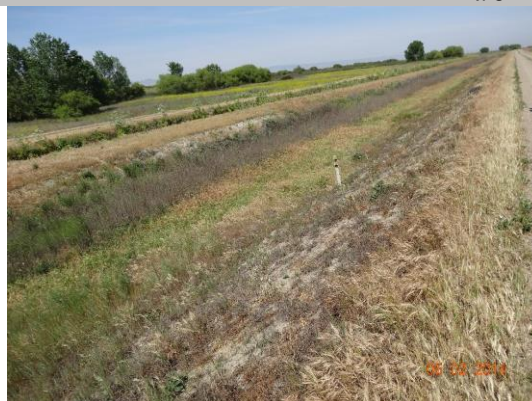
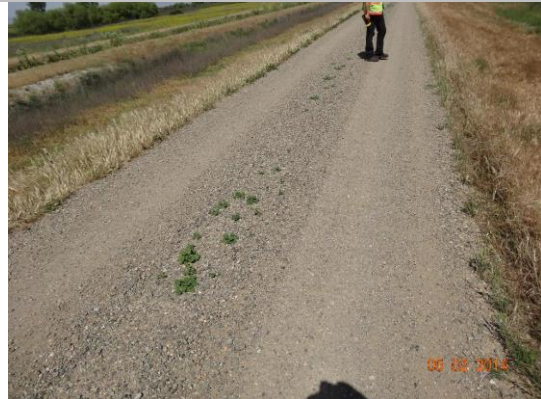
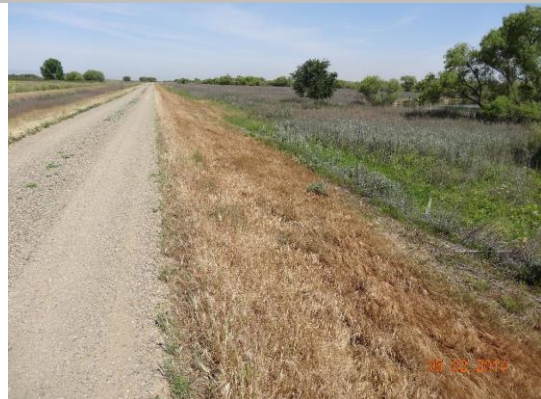
Photo 1 of 3 : UCIP\_SP\_2021\_62003\_66195.jpg

FS\_ID:62003  
 DS\_ID:19675  
 EP\_NO: N/A  
 Repair Type: Non-Urgent  
 Crossing Status: Found  
 UCIP Comments: 05/14/2014 Dense vegetation on landward toe. Also dense vegetation limits the inspector's visibility to identify signs of pipe failure (leaks) along waterward slope. Recommend removing vegetation along pipe alignment toe to conduct proper inspection of structure. Sediment buildup in pipe--recommend clearing. (O. Magana - DWR UCIP)  
 FIELD\_STRUCT\_DESC: 24-inch corrugated metal gravity drainage pipe through the levee, 9.4 feet below the crown. Flap gate on the waterside (WS) end. Brass cap No. 120 bench mark (BM) on the headwall on the landside (LS). [Additional Reference(s): DWR Levee Log, 2002 (HLM 8.49), listed as a 24-inch corrugated metal pipe (CMP). USACE San Joaquin O&M Manual, Unit 601 Part 1 (SJR 601.1), 1967, Revised 25 May 2011, (HLM 8.48), listed as a 24-inch CMP].  
 FS Date: 5/14/2014

View of landward side.

Overview of levee crown at crossing.

View of waterward side.

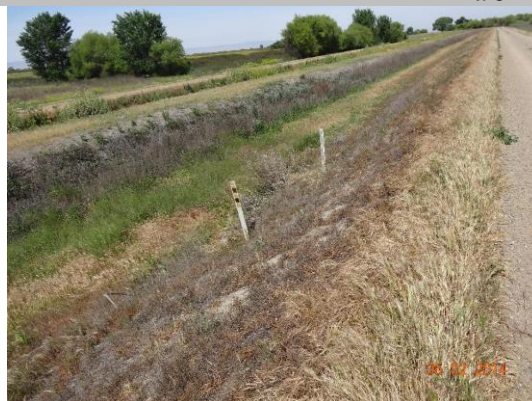
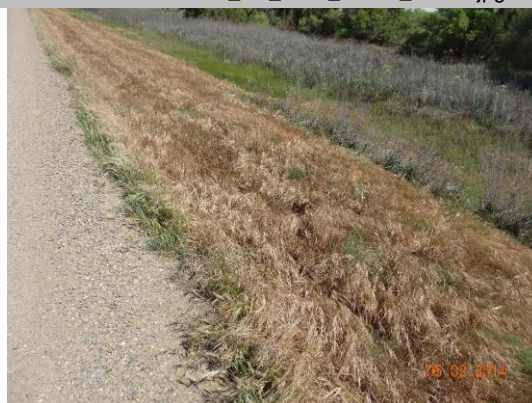
Photo 1 of 3 : UCIP\_SP\_2021\_62004\_66200.jpg

FS\_ID:62004  
DS\_ID:19676  
EP\_NO: N/A  
Repair Type: Non-Urgent  
Crossing Status: Found  
UCIP Comments: 05/14/2014 Dense vegetation limits the inspector's visibility to identify signs of pipe failure (leaks) along the slope. Recommend removing vegetation along pipe alignment to conduct proper inspection of structure. Burrow activity present on waterward slope. (O. Magana - DWR UCIP)  
FIELD\_STRUCT\_DESC: 24-inch corrugated metal gravity drainage pipe through the levee, 8.8 feet below the crown. Flap gate on the waterside (WS) end. Brass cap No. 120 bench mark (BM) on the headwall on the landside (LS). [Additional Reference(s): DWR Levee Log, 2002 (HLM 8.88), listed as a 24-inch corrugated metal pipe (CMP). USACE San Joaquin O&M Manual, Unit 601 Part 1 (SJR 601.1), 1967, Revised 25 May 2011, (recorded as HLM 9.86 should be HLM 8.86), listed as a 24-inch CMP].  
FS Date: 5/14/2014

View of landward side.

View of waterward side.

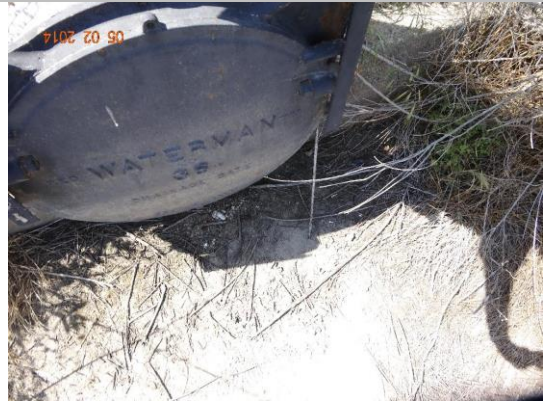
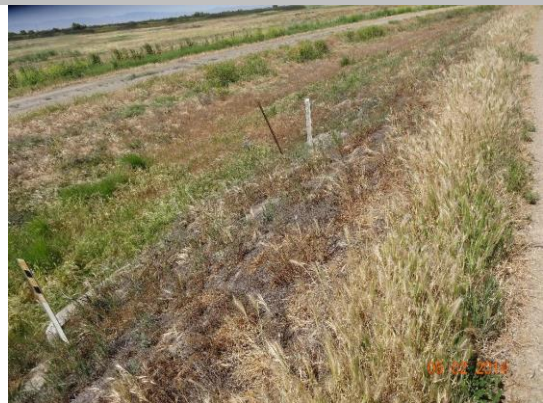
Photo 2 of 3 : UCIP\_SP\_2021\_62005\_66207.jpg

LM Start	9.00	Rating **	M	Issue No.	5 (cont)	
LM End	9.00	Issue Type +	Ma	Location *		
Category	Supplemental			GPS Latitude/Longitude		
				Start	End	
Item	DWR UCIP LMA Responsibility			37.220888 °	37.220888 °	
				-120.796394 °	-120.796394 °	
DWR ID	19677

View of flap gate visible from waterward side.

View of landward side.

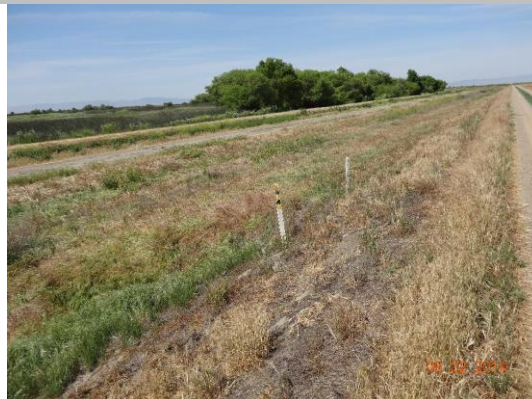
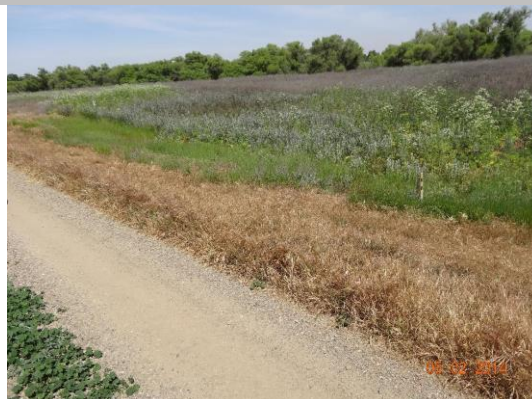
Photo 1 of 3 : UCIP\_SP\_2021\_62006\_66211.jpg

FS\_ID:62006  
DS\_ID:19678  
EP\_NO: N/A  
Repair Type: Non-Urgent  
Crossing Status: Found  
UCIP Comments: 05/14/2014 Dense vegetation limits the inspector's visibility to identify signs of pipe failure (leaks) along the slope. Recommend removing vegetation along pipe alignment to conduct proper inspection of structure. (O. Magana - DWR UCIP)  
FIELD\_STRUCT\_DESC: 24-inch corrugated metal gravity drainage pipe through the levee, 8 feet below the crown. Flap gate on the waterside (WS) end. Brass cap No. 120 bench mark (BM) on the headwall on the landside (LS). [Additional Reference(s): DWR Levee Log, 2002 (HLM 9.21), listed as a 24-inch corrugated metal pipe (CMP). USACE San Joaquin O&M Manual, Unit 601 Part 1 (SJR 601.1), 1967, Revised 25 May 2011, (HLM 9.20), listed as a 24-inch CMP].  
FS Date: 5/14/2014

View of landward side.

View of waterward side.

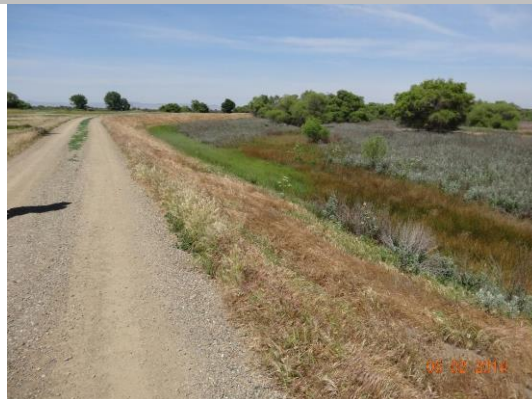
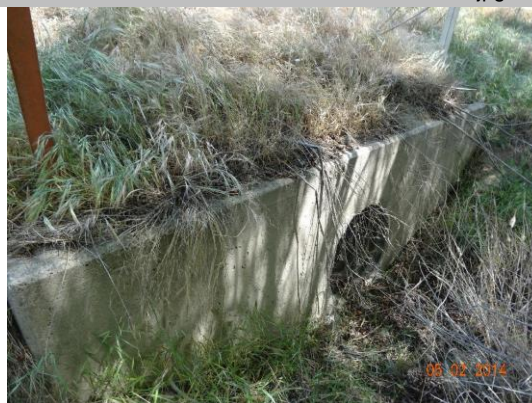
Photo 2 of 3 : UCIP\_SP\_2021\_62008\_66216.jpg

LM Start	<b>9.43</b>	Rating **	M	Issue No.	<b>7 (cont)</b>
LM End	<b>9.43</b>	Issue Type +	Ma	Location *	
Category	Supplemental		GPS Latitude/Longitude		
			Start	End	
Item	DWR UCIP LMA Responsibility		37.220227 °	37.220227 °	
			-120.788634 °	-120.788634 °	
DWR ID	19686

View of waterward side.

Concrete headwall visible on landward side.

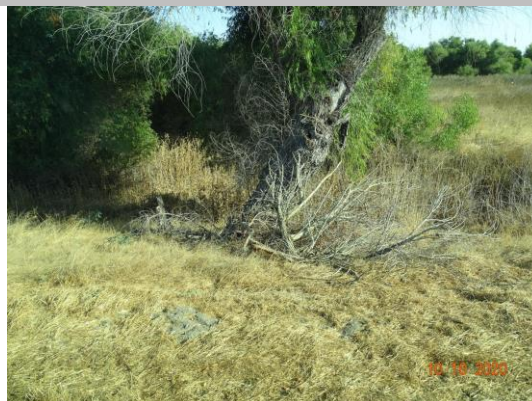
Photo 1 of 1 : SP\_2021\_NA0010\_120\_15\_20210308\_00003.jpg

LM Start	9.60	Rating **	M	Issue No.	15
LM End	9.60	Issue Type +	Ma	Location *	WS
Category	Earthen Levee			GPS Latitude/Longitude	
				Start	End
Item	Encroachments			37.220783 °	37.220783 °
				-120.785729 °	-120.785729 °
DWR ID	DWR_NA0010_02B_f_2020_15				
Comment Code					
TR : Tree or limb					
Inspector Comment					
Broken tree limbs on the waterside slope.

Tree limb on the waterside slope. (Fall 2020)

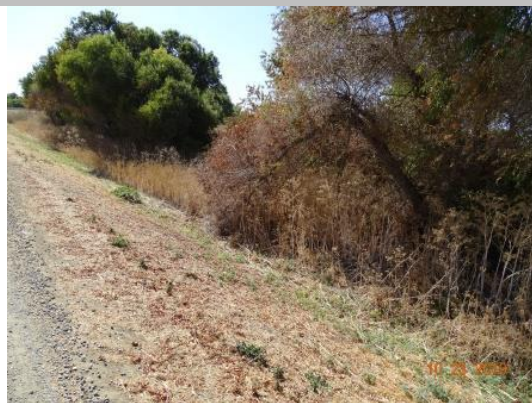
Photo 1 of 1 : SP\_2021\_NA0010\_120\_20\_20210308\_00005.jpg

LM Start	9.90	Rating **	M	Issue No.	20
LM End	9.90	Issue Type +	Ma	Location *	LS
Category	Earthen Levee			GPS Latitude/Longitude	
				Start	End
Item	Trim / Thin Trees			37.216923 °	37.216923 °
				-120.784007 °	-120.784007 °
DWR ID	DWR_NA0010_02B_f_2019_20				
Comment Code					
T1 : Trim trees to at least five feet above ground level.					
Inspector Comment					
Dead tree limb hanging on landside toe.

View of broken tree limb hanging over landside slope and toe. (Fall 2019)

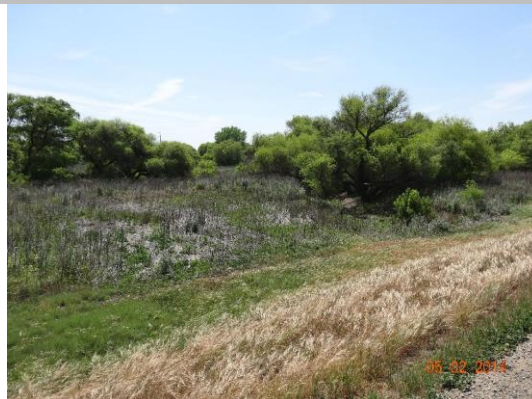
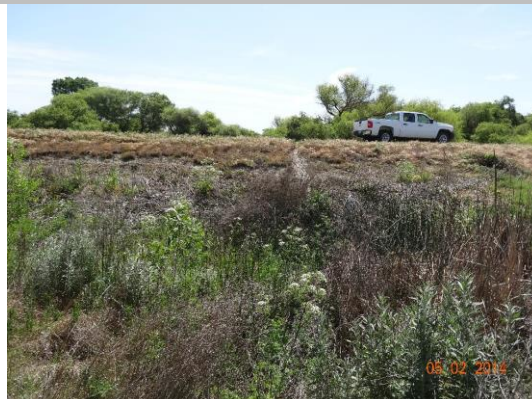
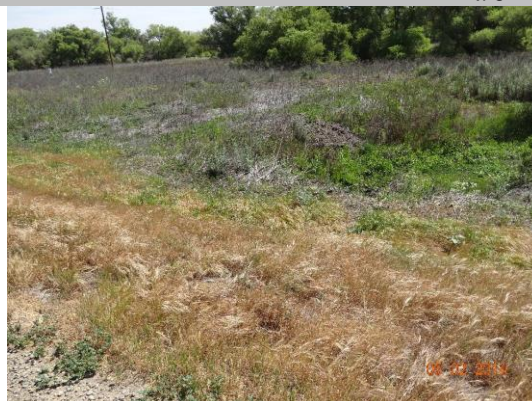
FS\_ID:62009  
DS\_ID:19687  
EP\_NO: N/A  
Repair Type: Non-Urgent  
Crossing Status: Found  
UCIP Comments: 05/14/2014 Dense vegetation limits the inspector's visibility to identify signs of pipe failure (leaks) along the slope. Recommend removing vegetation along pipe alignment to conduct proper inspection of structure. (O. Magana - DWR UCIP)  
FIELD\_STRUCT\_DESC: 24-inch corrugated metal gravity drainage pipe through the levee, 11.7 feet below the crown. Flap gate on the waterside (WS) end. Brass cap No. 115 bench mark (BM) on the headwall on the landside (LS). [Additional Reference(s): DWR Levee Log, 2002 (HLM 10.13), listed as a 24-inch corrugated metal pipe (CMP). USACE San Joaquin O&M Manual, Unit 601 Part 1 (SJR 601.1), 1967, Revised 25 May 2011, (HLM 10.12), listed as a 24-inch CMP].  
FS Date: 5/14/2014

Overview of waterward side.

View of waterward slope.

View of waterward side.

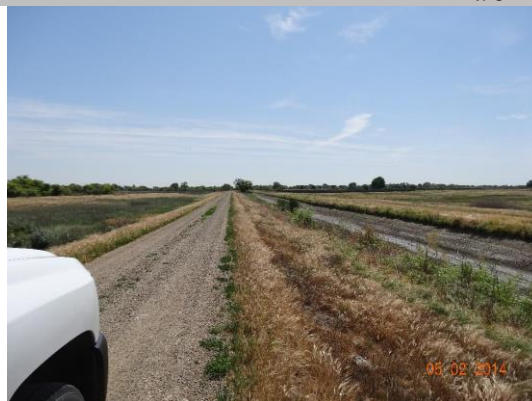
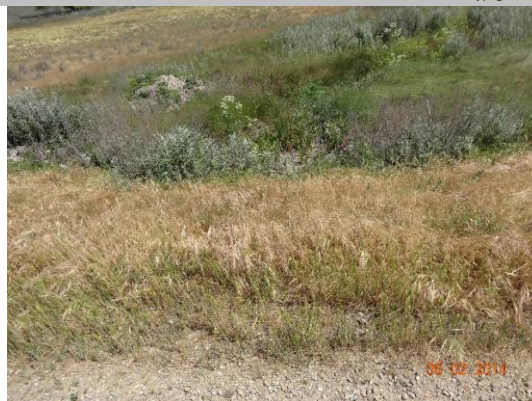
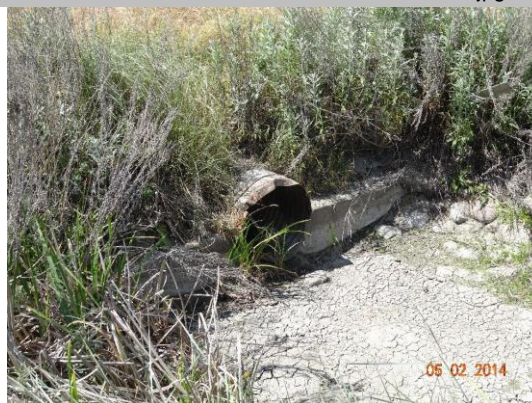
FS\_ID:62010  
 DS\_ID:19688  
 EP\_NO: N/A  
 Repair Type: Non-Urgent  
 Crossing Status: Found  
 UCIP Comments: 05/14/2014 Dense vegetation limits the inspector's visibility to identify signs of pipe failure (leaks) along the slope. Recommend removing vegetation along pipe alignment to conduct proper inspection of structure. Sediment buildup in pipe visible on landward side--recommend clearing. (O. Magana - DWR UCIP)  
 FIELD\_STRUCT\_DESC: 24-inch corrugated metal gravity drainage pipe through the levee, 8 feet below the crown. Flap gate on the waterside (WS) end. Brass cap No. 115 bench mark (BM) on the headwall on the landside (LS). [Additional Reference(s): DWR Levee Log, 2002 (HLM 10.82), listed as a 24-inch corrugated metal pipe (CMP). USACE San Joaquin O&M Manual, Unit 601 Part 1 (SJR 601.1), 1967, Revised 25 May 2011, (HLM 10.81), listed as a 24-inch CMP].  
 FS Date: 5/14/2014

View of landward side.

View of waterward side.

View of pipe visible on waterward side.

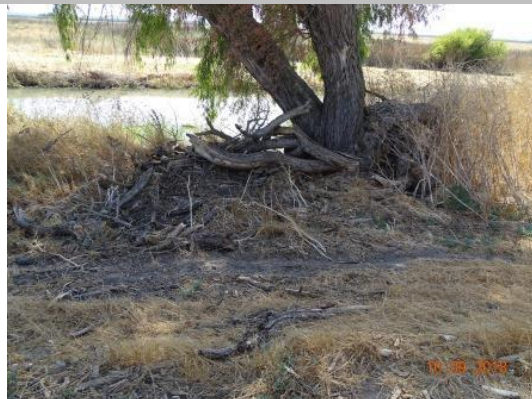
Photo 1 of 1 : SP\_2021\_NA0010\_120\_14\_20210308\_00002.jpg

LM Start	10.94	Rating **	M	Issue No.	14
LM End	10.94	Issue Type +	Ma	Location *	LS
Category	Earthen Levee			GPS Latitude/Longitude	
				Start	End
Item	Encroachments			37.205711 °	37.205711 °
				-120.774741 °	-120.774741 °
DWR ID	DWR_NA0010_02B_f_2015_14				
Comment Code					
PR : Prunings					
Inspector Comment					
Remove prunings from landside toe.

Prunings at landside toe. (Fall 2018)

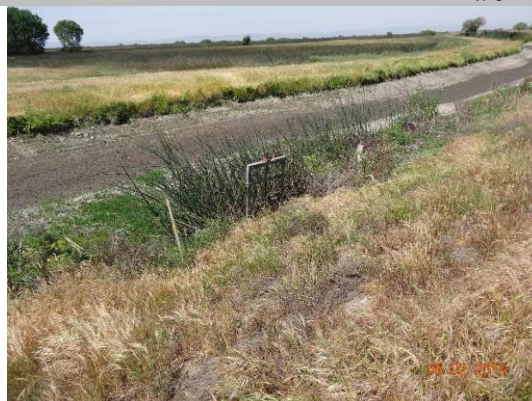
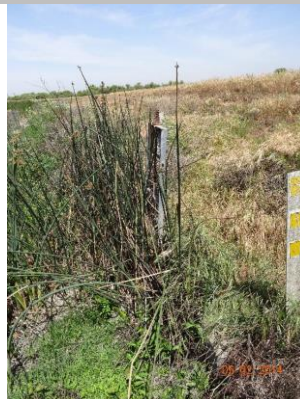
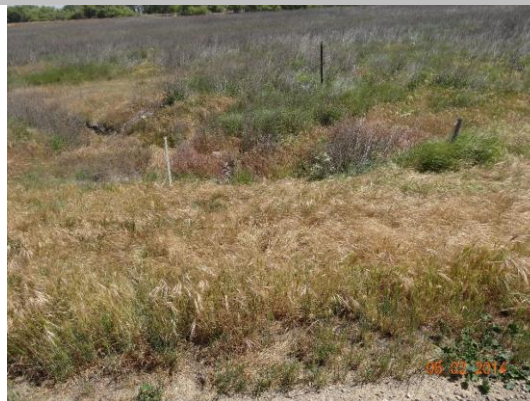
Comment Code						
Inspector Comment						
FS_ID:62012 DS_ID:19689 EP_NO: N/A Repair Type: Non-Urgent Crossing Status: Found UCIP Comments: 05/14/2014 Dense vegetation limits the inspector's visibility to identify signs of pipe failure (leaks) along the slope. Recommend removing vegetation along pipe alignment to conduct proper inspection of structure. (O. Magana - DWR UCIP) FIELD_STRUCT_DESC: 24-inch corrugated metal gravity drainage pipe through the levee, 8 feet below the crown. Flap gate on the waterside (WS) end. Brass cap No. 115 bench mark (BM) on the headwall on the landside (LS). [Additional Reference(s): DWR Levee Log, 2002 (HLM 11.18), listed as a 24-inch corrugated metal pipe (CMP). USACE San Joaquin O&M Manual, Unit 601 Part 1 (SJR 601.1), 1967, Revised 25 May 2011, (HLM 11.17), listed as a 24-inch CMP]. FS Date: 5/14/2014

View of landward slope.

Slide gate visible on landward side blocked by vegetation.

View of waterward side.

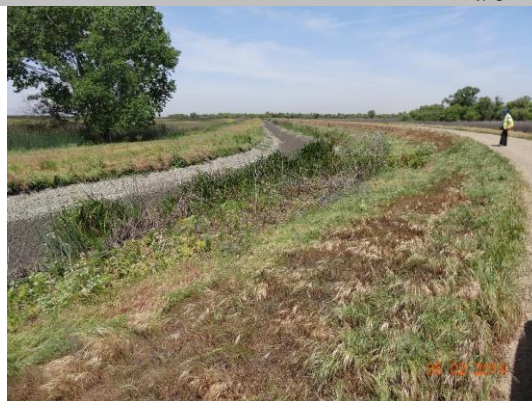
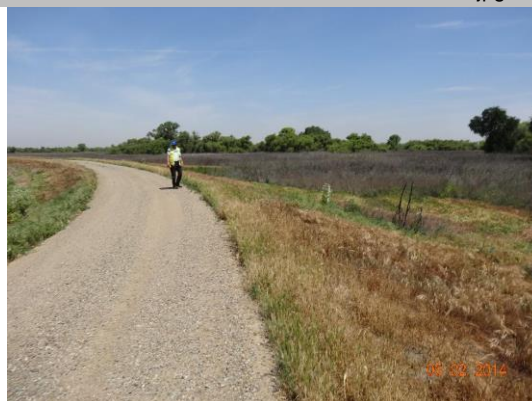
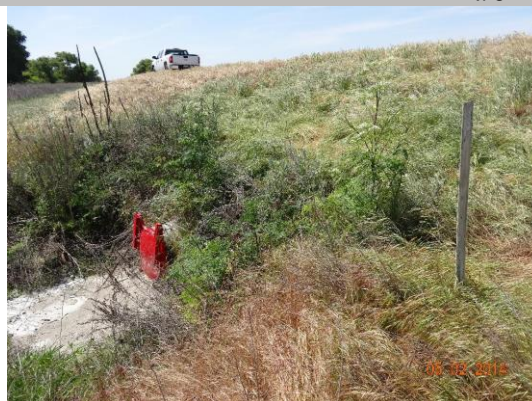
FS\_ID:62016  
DS\_ID:19690  
EP\_NO: N/A  
Repair Type: Non-Urgent  
Crossing Status: Found  
UCIP Comments: 05/14/2014 Dense vegetation limits the inspector's visibility to identify signs of pipe failure (leaks) along the slope. Recommend removing vegetation along pipe alignment to conduct proper inspection of structure. (O. Magana - DWR UCIP)  
FIELD\_STRUCT\_DESC: 24-inch corrugated metal gravity drainage pipe through the levee, 8 feet below the crown. Flap gate on the waterside (WS) end. Screw gate on the landside (LS). [Additional Reference(s): DWR Levee Log, 2002 (HLM 11.45), listed as a 24-inch corrugated metal pipe (CMP). USACE San Joaquin O&M Manual, Unit 601 Part 1 (SJR 601.1), 1967, Revised 25 May 2011, (HLM 11.43), listed as a 24-inch CMP].  
FS Date: 5/14/2014

View of landward side.

View of waterward side.

Flap gate visible on waterward toe.

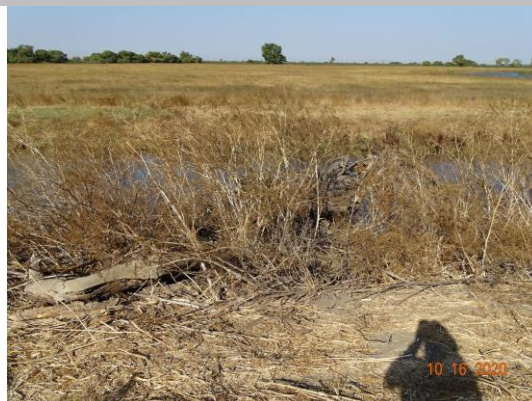
Photo 1 of 1 : SP\_2021\_NA0010\_120\_1\_20210308\_00001.jpg

LM Start	12.21	Rating **	M	Issue No.	1
LM End	12.21	Issue Type +	Ma	Location *	LS
Category	Earthen Levee			GPS Latitude/Longitude	
				Start	End
Item	Encroachments			37.191528 °	37.191528 °
				-120.764541 °	-120.764541 °
DWR ID	DWR_NA0010_02B_f_2014_1				
Comment Code					
TR : Tree or limb					
Inspector Comment					
Fallen tree limbs are located on the landside slope.

Fallen tree on the landside slope. (Fall 2020)

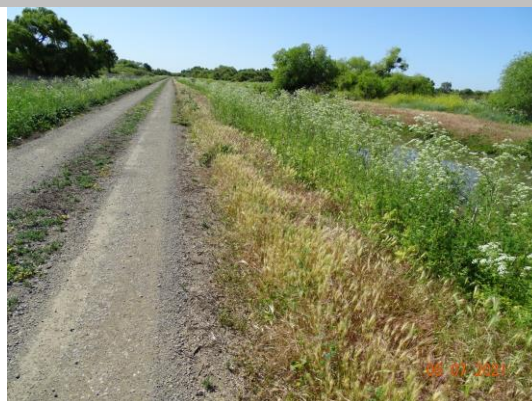
Photo 1 of 1 : SP\_2021\_NA0010\_120\_23\_20210517\_00043.jpg

LM Start	12.88	Rating **	U	Issue No.	23
LM End	13.49	Issue Type +	Ma	Location *	LS
Category	Earthen Levee			GPS Latitude/Longitude	
				Start	End
Item	Vegetation			37.183116 °	37.175818 °
				-120.767485 °	-120.761422 °
DWR ID	DWR_NA0010_02B_s_2021_23				
Comment Code					
V1 : Control annual grass and weeds on the levee slopes and easements.					
Inspector Comment

Looking upstream along the landside slope. (Spring 2021)
