# Flood Control Project Maintenance Levee Inspections LMA District Cover Sheet

## Lower San Joaquin Levee District

**Flood Control Project Maintenance  
Levee Inspections  
Unit Cover Sheet**

Waterway			Bank	Unit Miles
Unit No. 01 San Joaquin River			Right	22.52
	Spring (March - May)	Summer (June - August)	(September - November) Fall	Winter (December - February)
Unit Maintenance Rating (Fall Only)				
Date of Inspection	5/4/2021 - 5/4/2021			
DWR Inspector	Corey Fujitani			
Accompanied By

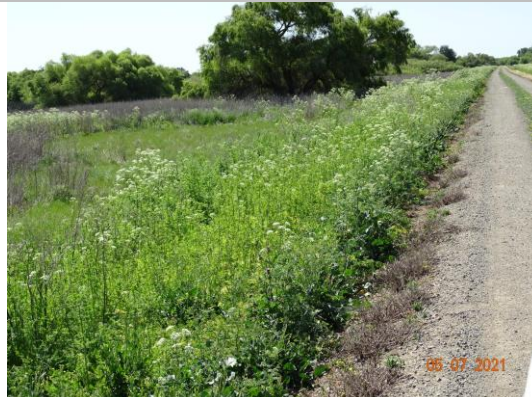
Photo 1 of 1 : SP\_2021\_NA0010\_120\_21\_20210517\_00044.jpg

LM Start	12.88	Rating **	U	Issue No.	21
LM End	13.38	Issue Type +	Ma	Location *	WS
Category	Earthen Levee			GPS Latitude/Longitude	
				Start	End
Item	Vegetation			37.183114 °	37.176860 °
				-120.767481 °	-120.762968 °
DWR ID	DWR_NA0010_02B_s_ 2021_21				
Comment Code					
V1 : Control annual grass and weeds on the levee slopes and easements.					
Inspector Comment

View of vegetation growing on the waterside slope. (Spring 2021)

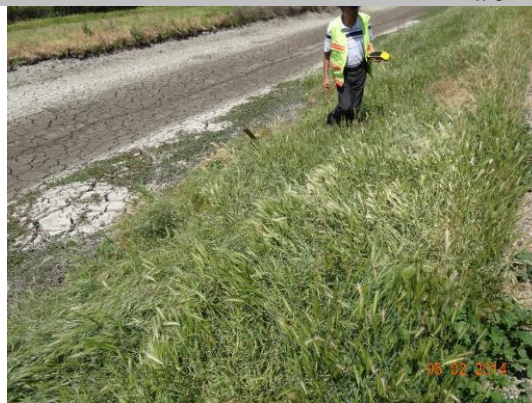
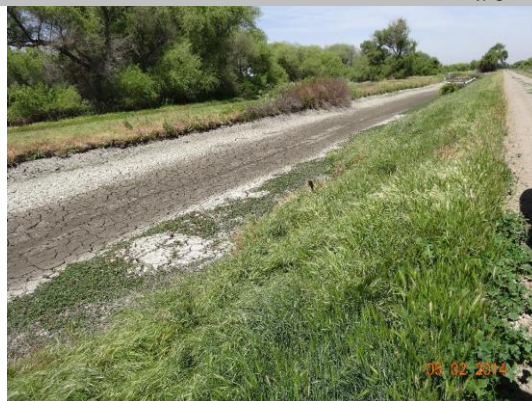
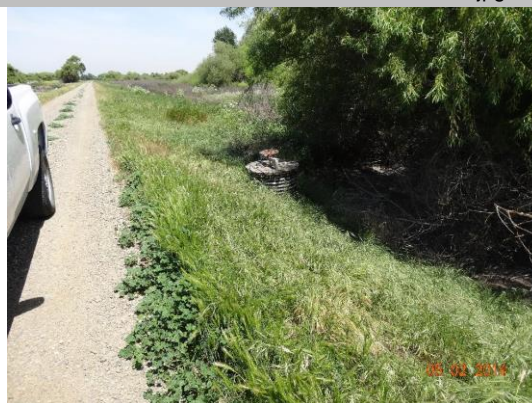
Comment Code					
Inspector Comment					
FS_ID:62018 DS_ID:19663 EP_NO: N/A Repair Type: Non-Urgent Crossing Status: Found UCIP Comments: 05/14/2014 Dense vegetation limits the inspector's visibility to identify signs of pipe failure (leaks) along the slope. Recommend removing vegetation along pipe alignment to conduct proper inspection of structure. Sediment buildup in pipe--recommend clearing. (O. Magana - DWR UCIP) FIELD_STRUCT_DESC: 24-inch corrugated metal gravity drainage pipe through the levee, 6.5 feet below the crown. Slide gate in a pipe riser on the waterside (WS) slope. [Additional Reference(s): DWR Levee Log, 2002 (HLM 13.23), listed as a 24-inch corrugated metal pipe (CMP). USACE San Joaquin O&M Manual, Unit 601 Part 1 (SJR 601.1), 1967, Revised 25 May 2011, (recorded as HLM 13.32 should be HLM 13.22), listed as a 24-inch CMP]. FS Date: 5/14/2014

View of landward side.

Overview of landward slope.

View of waterward side.

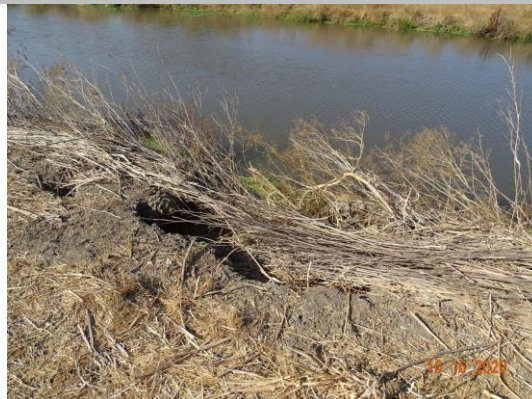
Photo 1 of 1 : SP\_2021\_NA0010\_120\_25\_20210308\_00007.jpg

LM Start	13.72	Rating **	M	Issue No.	25
LM End	13.72	Issue Type +	Ma	Location *	LS
Category	Earthen Levee			GPS Latitude/Longitude	
				Start	End
Item	Erosion / Bank Caving			37.172648 °	37.172648 °
				-120.761157 °	-120.761157 °
DWR ID	DWR_NA0010_02B_f_2018_25				
Comment Code					
E1 : Note and monitor erosion site.					
Inspector Comment					
Erosion is occurring into the landside bank.

View of erosion pocket in the landside slope. (Fall 2020)

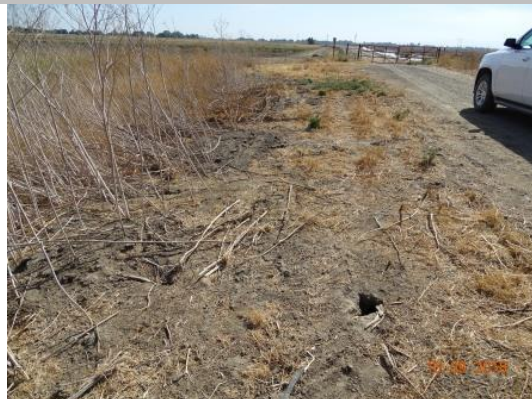
Photo 1 of 1 : SP\_2021\_NA0010\_120\_22\_20210308\_00006.jpg

LM Start	13.73	Rating **	M	Issue No.	22
LM End	13.73	Issue Type +	Ma	Location *	WS
Category	Earthen Levee			GPS Latitude/Longitude	
				Start	End
Item	Animal Control			37.172387 °	37.172387 °
				-120.761190 °	-120.761190 °
DWR ID	DWR_NA0010_02B_f_2018_22				
Comment Code					
A1 : Exterminate rodents and backfill and compact or grout burrows.					
Inspector Comment					
There are several rodent burrows observed at this location.

View of waterside slope looking upstream. (Fall 2018)

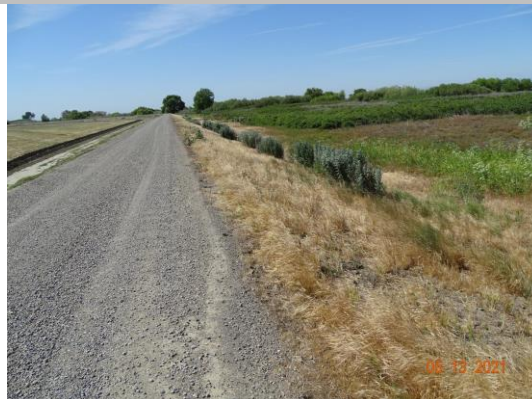
Photo 1 of 1 : SP\_2021\_NA0010\_121\_7\_20210517\_00021.jpg

LM Start	0.06	Rating **	M	Issue No.	7
LM End	0.42	Issue Type +	Ma	Location *	WS
Category	Earthen Levee			GPS Latitude/Longitude	
				Start	End
Item	Vegetation			37.110908 °	37.106145 °
				-120.587784 °	-120.585716 °
DWR ID	DWR_NA0010_03_s_2021_7				
Comment Code					
V1 : Control annual grass and weeds on the levee slopes and easements.					
Inspector Comment

View of the waterside slope looking upstream. (Spring 2021)

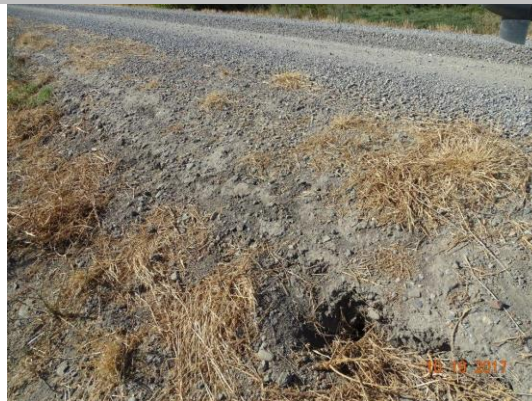
Photo 1 of 1 : SP\_2021\_NA0010\_121\_67\_20210308\_00008.jpg

LM Start	0.19	Rating **	M	Issue No.	67
LM End	0.19	Issue Type +	Ma	Location *	LS
Category	Earthen Levee			GPS Latitude/Longitude	
				Start	End
Item	Animal Control			37.109013 °	37.109013 °
				-120.587799 °	-120.587799 °
DWR ID	DWR_NA0010_03_s_2015_67				
Comment Code					
A3 : No rodents visible, but rodent burrows visible; need to backfill and compact or grout burrows.					
Inspector Comment					
Rodent holes are noted on the landside slope.

Looking southwest at the landside shoulder.

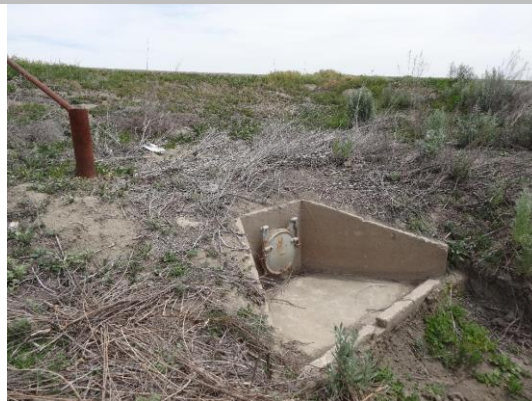
Photo 1 of 3 : UCIP\_SP\_2021\_62020\_61941.jpg

Comment Code						
Inspector Comment						
FS_ID:62020 DS_ID:19691 EP_NO: N/A Repair Type: Non-Urgent Crossing Status: Found UCIP Comments: 04/17/2014 Need to contact owner. Recommend removing tall grass on landward slope and clearing sediment build up inside pipe. (O. Magana - DWR UCIP) FIELD_STRUCT_DESC: 24-inch corrugated metal gravity drainage pipe through the levee, 11.3 feet below the crown. Flap gate on the waterside (WS) end. [Additional Reference(s): DWR Levee Log, 2002 (HLM 0.43), listed as a 24-inch corrugated metal pipe (CMP). USACE San Joaquin O&M Manual, Unit 601 Part 1 (SJR 601.1), 1967, Revised 25 May 2011, (HLM 0.43), listed as a 24-inch CMP]. FS Date: 4/17/2014

Concrete structure and flap gate visible on waterward side.

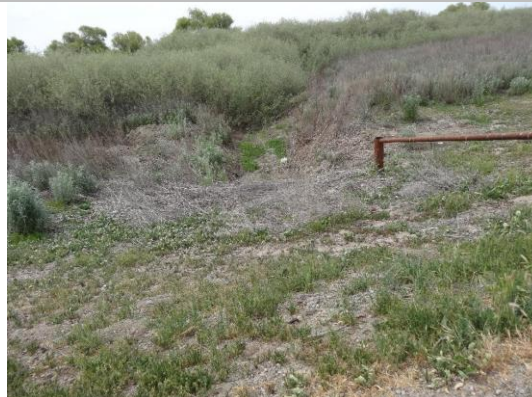
Photo 2 of 3 : UCIP\_SP\_2021\_62020\_61940.jpg

View of waterward side.

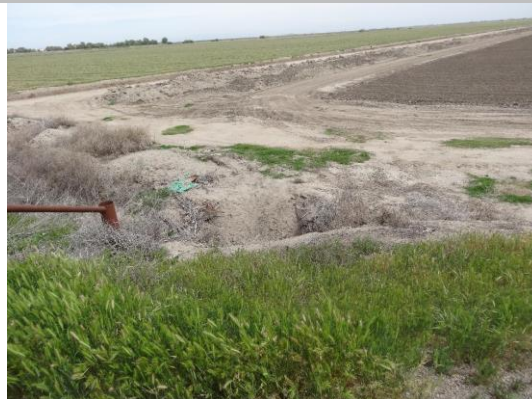
Photo 3 of 3 : UCIP\_SP\_2021\_62020\_61944.jpg

View of landward side.

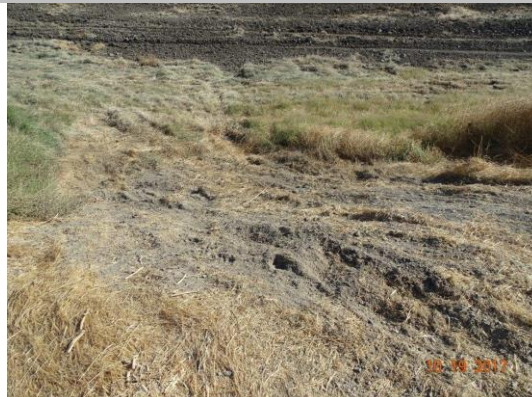
Photo 1 of 1 : SP\_2021\_NA0010\_121\_6\_20210308\_00002.jpg

LM Start	0.43	Rating **	M	Issue No.	6
LM End	0.43	Issue Type +	Ma	Location *	LS
Category	Earthen Levee			GPS Latitude/Longitude	
				Start	End
Item	Slope Stability			37.106121 °	37.106121 °
				-120.585680 °	-120.585680 °
DWR ID	DWR_NA0010_03_f _ 2017_6				
Comment Code					
S3 : Repair the levee slope damaged by vehicle traffic and prevent access where possible.					
Inspector Comment

Looking east at the landside slope.

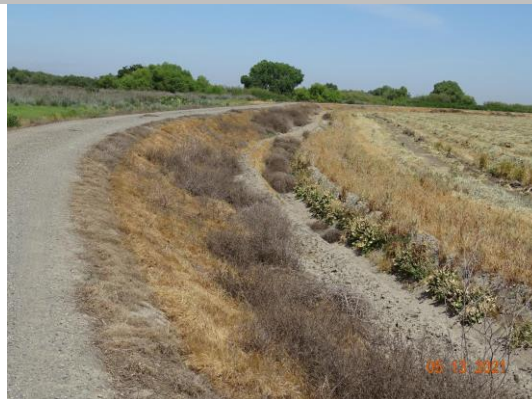
Photo 1 of 1 : SP\_2021\_NA0010\_121\_13\_20210517\_00022.jpg

LM Start	0.43	Rating **	M	Issue No.	13
LM End	2.02	Issue Type +	En	Location *	LS
Category	Earthen Levee			GPS Latitude/Longitude	
				Start	End
Item	Encroachments			37.106072 °	37.089499 °
				-120.585636 °	-120.568041 °
DWR ID	DWR_NA0010_03_s_2021_13				
Comment Code					
DT : Ditch					
Inspector Comment					
Landowner has dug a ditch in the landside toe.

View of ditch dug on the landside toe. (Spring 2021)

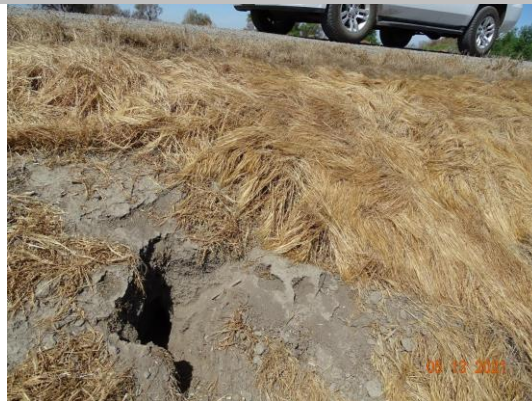
Photo 1 of 1 : SP\_2021\_NA0010\_121\_10\_20210517\_00023.jpg

LM Start	0.57	Rating **	U	Issue No.	10
LM End	0.57	Issue Type +	Ma	Location *	LS
Category	Earthen Levee			GPS Latitude/Longitude	
				Start	End
Item	Animal Control			37.104343 °	37.104343 °
				-120.584348 °	-120.584348 °
DWR ID	DWR_NA0010_03_s_2021_10				
Comment Code					
A3 : No rodents visible, but rodent burrows visible; need to backfill and compact or grout burrows.					
Inspector Comment

Several large rodent burrows observed at this location. (Spring 2021)

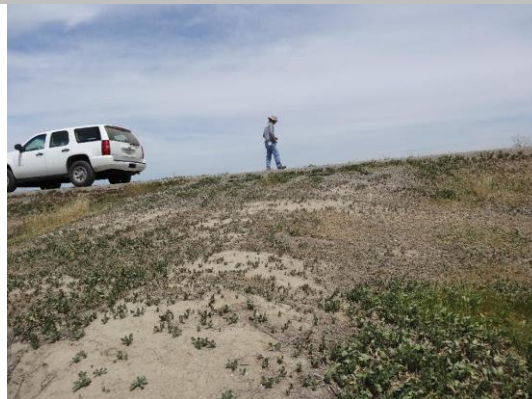
Photo 1 of 3 : UCIP\_SP\_2021\_62022\_66248.jpg

View of waterward slope.

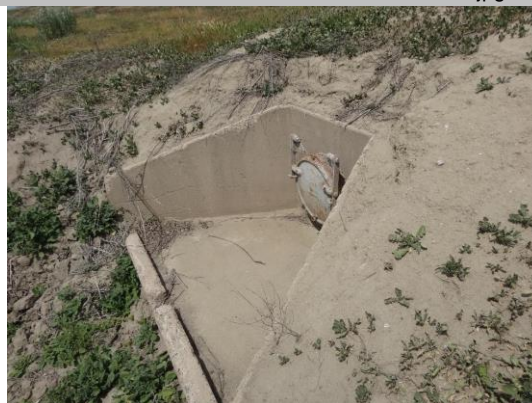
Photo 2 of 3 : UCIP\_SP\_2021\_62022\_66249.jpg

Concrete structure located on waterward side.

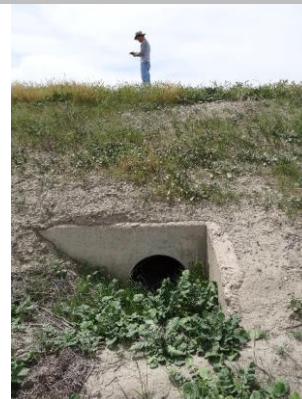
Photo 3 of 3 : UCIP\_SP\_2021\_62022\_66251.jpg

View of landward slope.

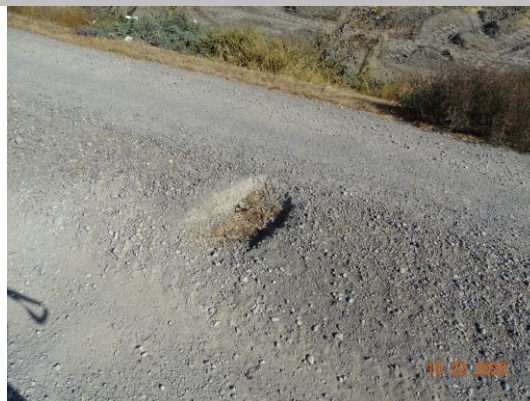
Photo 1 of 1 : SP\_2021\_NA0010\_121\_8\_20210308\_00004.jpg

LM Start	0.86	Rating **	M	Issue No.	8
LM End	0.86	Issue Type +	Ma	Location *	CR
Category	Earthen Levee			GPS Latitude/Longitude	
				Start	End
Item	Animal Control			37.101821 °	37.101821 °
				-120.580358 °	-120.580358 °
DWR ID	DWR_NA0010_03_f_2020_8				
Comment Code					
A3 : No rodents visible, but rodent burrows visible; need to backfill and compact or grout burrows.					
Inspector Comment

Depression in the levee crown from rodent activity. (Fall 2020)

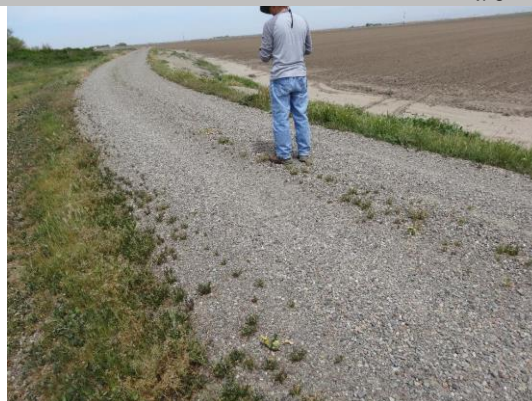
Photo 1 of 3 : UCIP\_SP\_2021\_62023\_66252.jpg

Comment Code						
Inspector Comment						
FS_ID:62023						
DS_ID:19693						
EP_NO: N/A						
Repair Type: Non-Urgent						
Crossing Status: Found						
UCIP Comments: 04/17/2014 Sediment buildup in pipe visible from landward side--recommend clearing. (O. Magana - DWR UCIP)						
FIELD_STRUCT_DESC: 24-inch corrugated metal gravity drainage pipe through the levee, 6.8 feet below the crown. Flap gate on the waterside (WS) end. [Additional Reference(s): DWR Levee Log, 2002 (HLM 1.73), listed as a 24-inch corrugated metal pipe (CMP). USACE San Joaquin O&M Manual, Unit 601 Part 1 (SJR 601.1), 1967, Revised 25 May 2011, (HLM 1.72), listed as a 24-inch CMP].						
FS Date: 4/17/2014

View of levee crown at crossing.

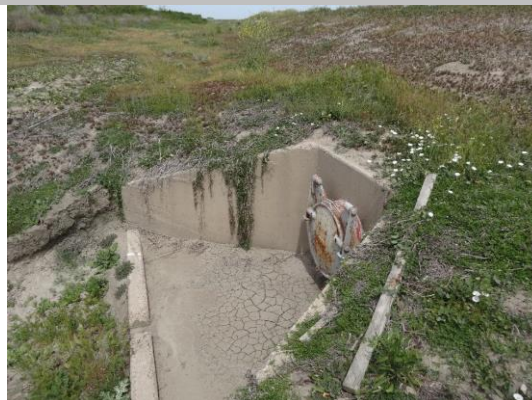
Photo 2 of 3 : UCIP\_SP\_2021\_62023\_66254.jpg

Concrete structure located on waterward side.

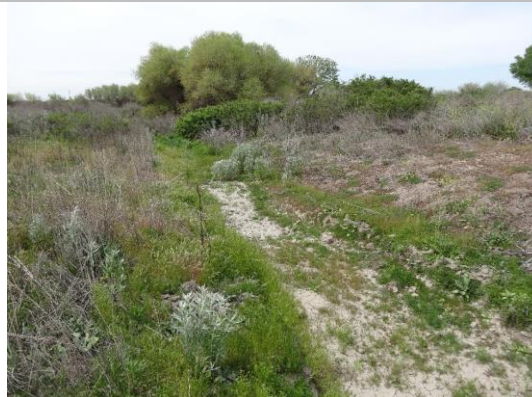
Photo 3 of 3 : UCIP\_SP\_2021\_62023\_66253.jpg

View of waterward side--channel.

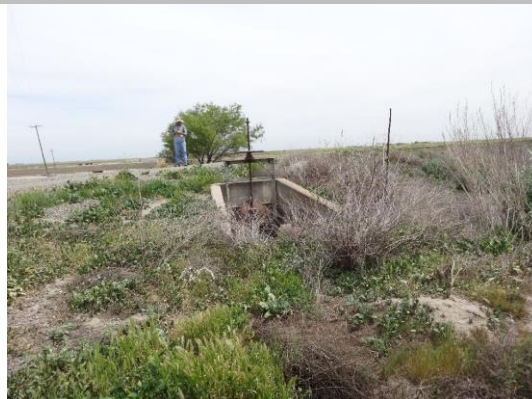
Photo 1 of 3 : UCIP\_SP\_2021\_62024\_66281.jpg

FS\_ID:62024  
DS\_ID:19694  
EP\_NO: N/A  
Repair Type: Non-Urgent  
Crossing Status: Found  
UCIP Comments: 04/17/2014 Need to contact owner--additional appurtenances found on waterward side not part of original description. Unable to determine if walkway, pump, and pipe through waterward berm is if part of original crossing. (O. Magana - DWR UCIP)  
FIELD\_STRUCT\_DESC: 36-inch corrugated metal irrigation discharge pipe through the levee, 6.6 feet below the crown. Pump on the riverbank. Slide gate on the waterside (WS) end. [Additional Reference(s): DWR Levee Log, 2002 (HLM 2.05), listed as a 36-inch corrugated metal pipe (CMP). USACE San Joaquin O&M Manual, Unit 601 Part 1 (SJR 601.1), 1967, Revised 25 May 2011, (HLM 2.05), listed as a 36-inch CMP].  
FS Date: 4/17/2014

Slide gate and concrete structure located on waterward slope.

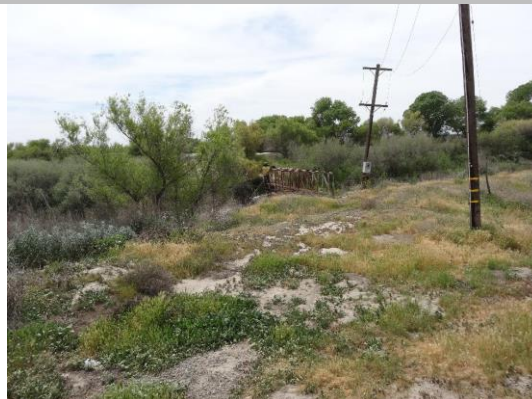
Photo 2 of 3 : UCIP\_SP\_2021\_62024\_66282.jpg

View of walkway and berm on waterward side.

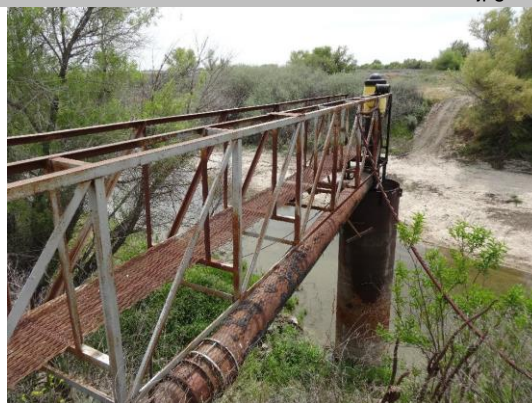
Photo 3 of 3 : UCIP\_SP\_2021\_62024\_66280.jpg

Pump and damage walkway located on waterward side.

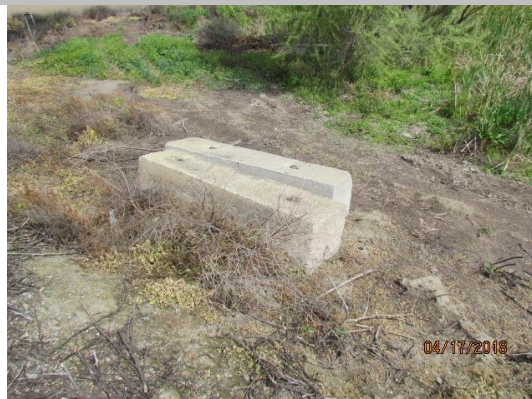
Photo 1 of 1 : SP\_2021\_NA0010\_121\_5\_20210308\_00001.jpg

LM Start	2.05	Rating **	U	Issue No.	5
LM End	2.05	Issue Type +	En	Location *	LS
Category	Earthen Levee			GPS Latitude/Longitude	
				Start	End
Item	Encroachments			37.089289 °	37.089289 °
				-120.567463 °	-120.567463 °
DWR ID	DWR_NA0010_03_s_2018_5				
Comment Code					
MA : Material					
Inspector Comment					
Two large concrete blocks are located on the landward toe.

Looking southwest at concrete blocks on landward toe. (Spring 2018)

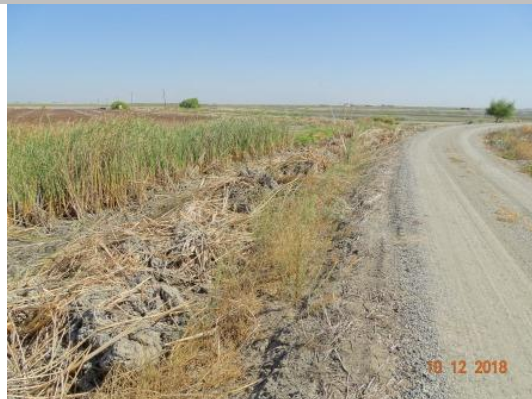
Photo 1 of 1 : SP\_2021\_NA0010\_121\_14\_20210308\_00006.jpg

LM Start	2.07	Rating **	M	Issue No.	14
LM End	2.09	Issue Type +	En	Location *	LS
Category	Earthen Levee			GPS Latitude/Longitude	
				Start	End
Item	Encroachments			37.089177 °	37.089070 °
				-120.567126 °	-120.566977 °
DWR ID	DWR_NA0010_03_f_2018_14				
Comment Code					
DE : Debris					
Inspector Comment					
Debris from ditch dredging left on landside slope.

View of debris from dredging left on landside slope. (Fall 2018)

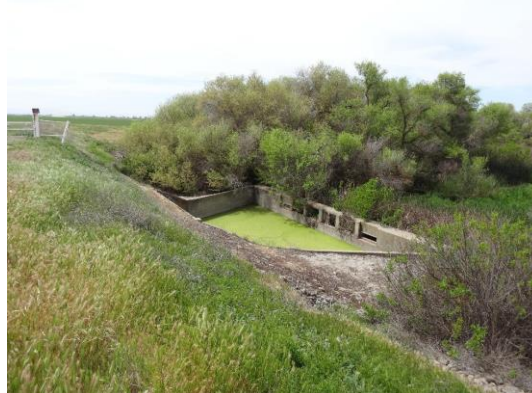
Photo 1 of 3 : UCIP\_SP\_2021\_62025\_61969.jpg

View of concrete structure located on landward side.

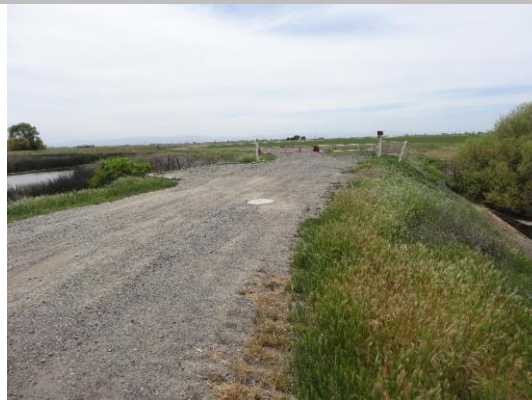
Photo 2 of 3 : UCIP\_SP\_2021\_62025\_61968.jpg

View of levee crown.

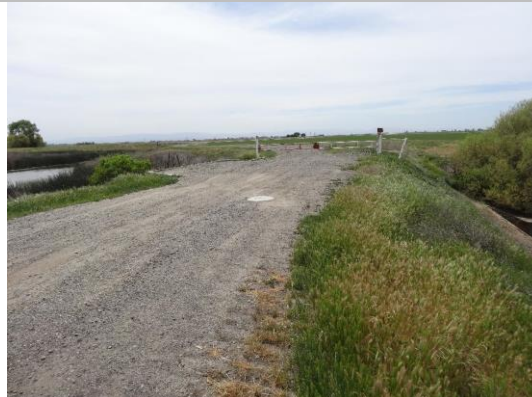
Photo 2 of 3 : UCIP\_SP\_2021\_62026\_67307.jpg

View of levee crown.

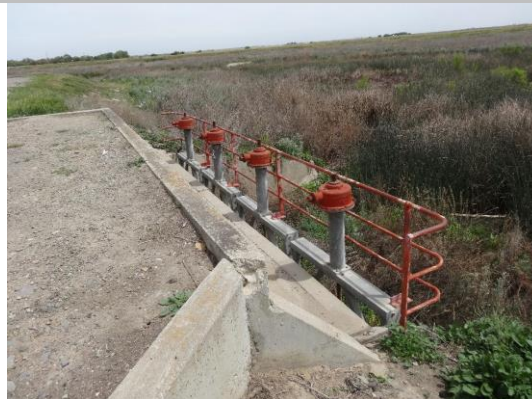
Photo 3 of 3 : UCIP\_SP\_2021\_62026\_67306.jpg

Concrete headwall located on waterward side.

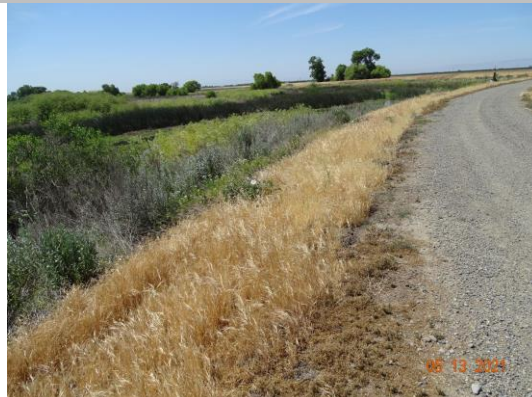
Photo 1 of 1 : SP\_2021\_NA0010\_122\_8\_20210517\_00022.jpg

LM Start	0.05	Rating **	M	Issue No.	8
LM End	0.63	Issue Type +	Ma	Location *	WS
Category	Earthen Levee			GPS Latitude/Longitude	
				Start	End
Item	Vegetation			37.112213 °	37.105084 °
				-120.589838 °	-120.587800 °
DWR ID	DWR_NA0010_04_s_2021_8				
Comment Code					
V1 : Control annual grass and weeds on the levee slopes and easements.					
Inspector Comment

View of vegetation on the waterside slope looking upstream. (Spring 2021)

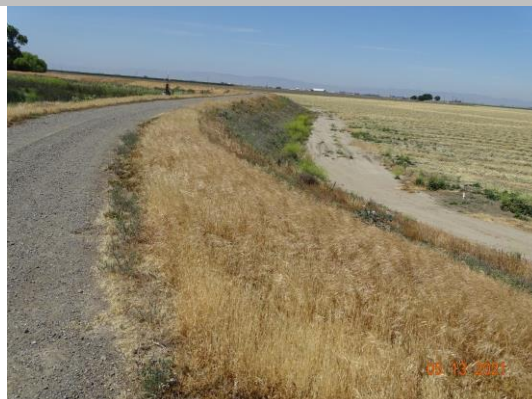
Photo 1 of 1 : SP\_2021\_NA0010\_122\_9\_20210517\_00023.jpg

LM Start	0.07	Rating **	M	Issue No.	9
LM End	0.32	Issue Type +	Ma	Location *	LS
Category	Earthen Levee			GPS Latitude/Longitude	
				Start	End
Item	Vegetation			37.112055 °	37.108774 °
				-120.589978 °	-120.590728 °
DWR ID	DWR_NA0010_04_s_2021_9				
Comment Code					
V1 : Control annual grass and weeds on the levee slopes and easements.					
Inspector Comment

View of the landside slope looking upstream. (Spring 2021)

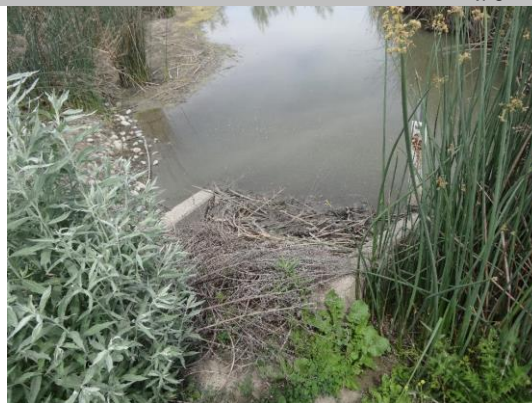
Photo 1 of 3 : UCIP\_SP\_2021\_62029\_61982.jpg

Comment Code						
Inspector Comment						
FS_ID:62029 DS_ID:19695 EP_NO: N/A Repair Type: Non-Urgent Crossing Status: Found UCIP Comments: 04/17/2014 Sediment and debris blocking concrete headwall located on waterward side. During inspection water was flowing from landward side to waterward side. Recommend removing sediment to confirm condition of flap gate and pipe. (O. Magana - DWR UCIP) FIELD_STRUCT_DESC: 36-inch corrugated metal gravity drainage pipe through the levee, 18 feet below the crown. Flap gate on the waterside (WS) end. Concrete headwall on each end. [Additional Reference(s): DWR Levee Log, 2002[Additional Resource(s): DWR Levee Log, 2002 (HLM 0.03), listed as four 6-foot by 5-foot concrete culverts] (HLM 0.24), listed as a 36-inch corrugated metal pipe (CMP). USACE San Joaquin O&M Manual, Unit 601 Part 1 (SJR 601.1), 1967, Revised 25 May 2011, (HLM 0.27), listed as a 36-inch CMP]. FS Date: 4/17/2014

View of dense vegetation near concrete headwall located on waterward side.

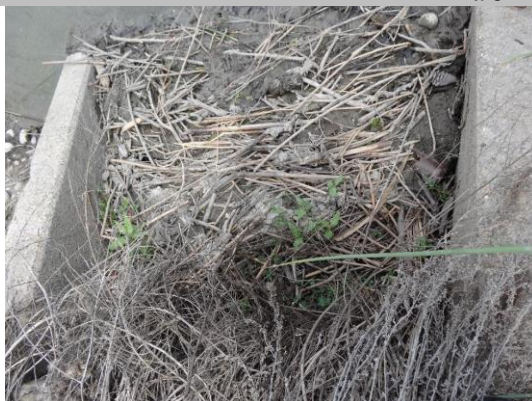
Photo 2 of 3 : UCIP\_SP\_2021\_62029\_61981.jpg

Sediment blocking flap gate located on waterward side.

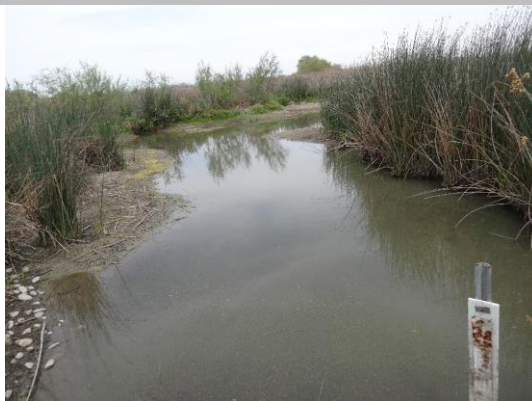
Photo 3 of 3 : UCIP\_SP\_2021\_62029\_61980.jpg

View of waterward side.

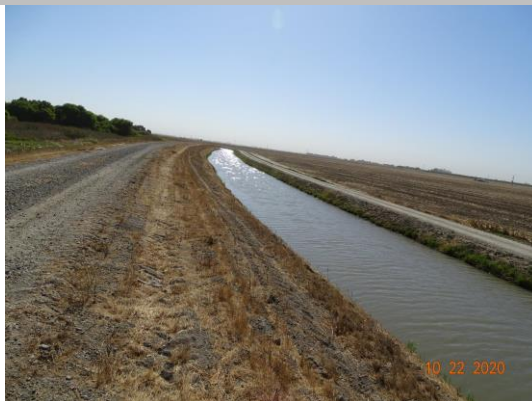
Photo 1 of 1 : SP\_2021\_NA0010\_122\_3\_20210308\_00001.jpg

LM Start	0.32	Rating **	M	Issue No.	3
LM End	1.41	Issue Type +	En	Location *	LS
Category	Earthen Levee			GPS Latitude/Longitude	
				Start	End
Item	Encroachments			37.108822 °	37.097556 °
				-120.590718 °	-120.578130 °
DWR ID	DWR_NA0010_04_s_2012_3				
Comment Code					
DT : Ditch					
Inspector Comment					
An irrigation ditch is within 10' easement.

Looking upstream at an irrigation ditch at the landside toe. (Fall 2020)

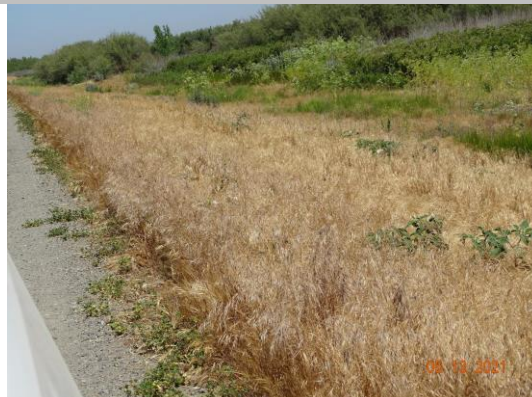
Photo 1 of 1 : SP\_2021\_NA0010\_122\_10\_20210517\_00021.jpg

LM Start	0.87	Rating **	U	Issue No.	10
LM End	1.40	Issue Type +	Ma	Location *	WS
Category	Earthen Levee			GPS Latitude/Longitude	
				Start	End
Item	Vegetation			37.102921 °	37.097667 °
				-120.584430 °	-120.578135 °
DWR ID	DWR_NA0010_04_s_2021_10				
Comment Code					
V1 : Control annual grass and weeds on the levee slopes and easements.					
Inspector Comment

View of the waterside slope looking downstream. (Spring 2021)

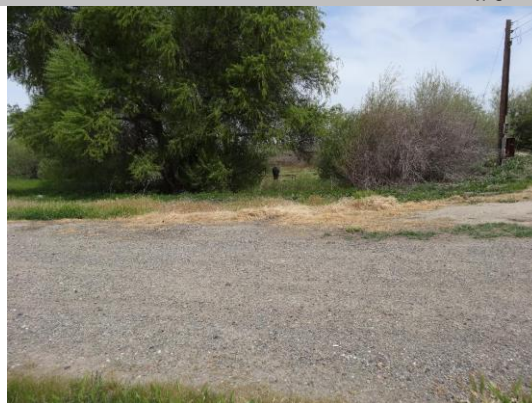
Photo 1 of 3 : UCIP\_SP\_2021\_40530\_61987.jpg

LM Start	1.34	Rating **	M	Issue No.	7	
LM End	1.34	Issue Type +	En	Location *		
Category	Supplemental			GPS Latitude/Longitude		
				Start	End	
Item	DWR UCIP Field Study			37.095274 °	37.095274 °	
				-120.577959 °	-120.577959 °	
DWR ID	19975					
Comment Code						
Inspector Comment						
FS_ID:40530						
DS_ID:19975						
EP_NO: 3416						
Repair Type: Non-Urgent						
Crossing Status: Found						
UCIP Comments: Unable to confirm if crossing is still in use. Need to contact owner to confirm status.						
FIELD_STRUCT_DESC: 12-inch steel irrigation pipe, encased in 6-inches of reinforced concrete through the levee. Concrete cutoff wall at center of levee. Pumping plant on the waterward bank. Pump and irrigation pipe retained under Permit No. 3416 (1964).						
FS Date: 4/17/2014

View of waterward side.

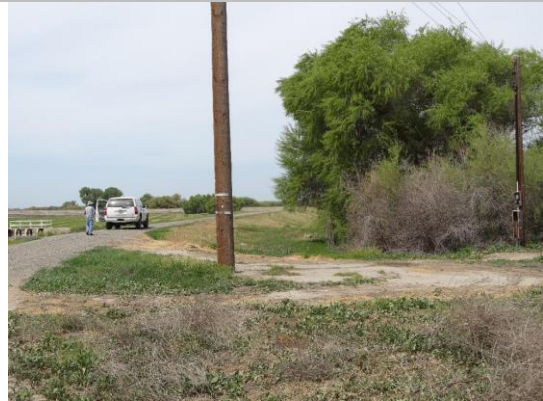
Photo 2 of 3 : UCIP\_SP\_2021\_40530\_61988.jpg

Overview of waterward side and levee crown at crossing.

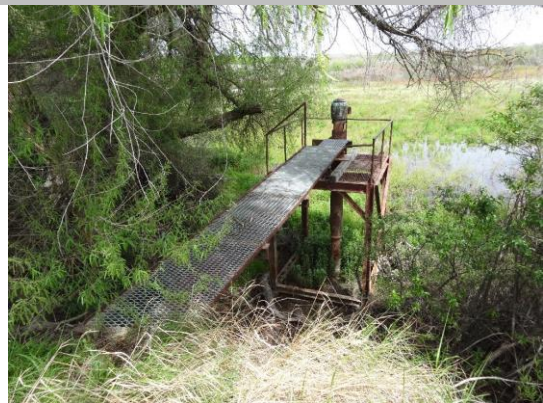
Photo 3 of 3 : UCIP\_SP\_2021\_40530\_61986.jpg

Pump and walkway located on waterward side.

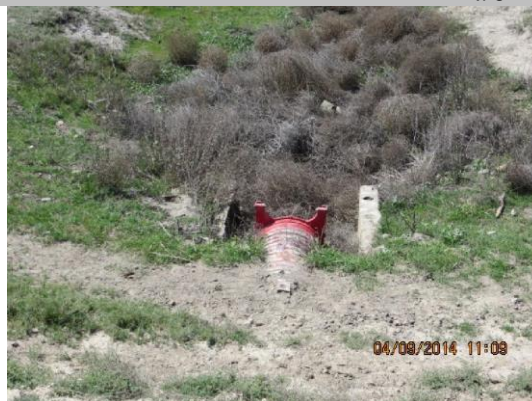
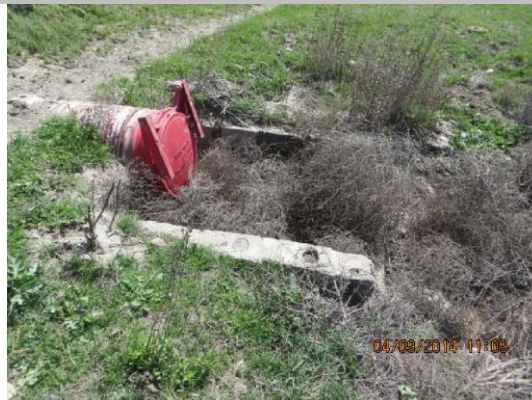
FS\_ID:62422  
DS\_ID:19756  
EP\_NO: N/A  
Repair Type: Non-Urgent  
Crossing Status: Found  
UCIP Comments: 04/09/2014 Debris blocking landward headwall--recommend clearing. (W. Wylie - DWR UCIP)  
FIELD\_STRUCT\_DESC: 24-inch corrugated metal gravity drainage pipe through the levee, 8.6 feet below the crown. Concrete U-shaped headwall and flap gate on the waterside (WS) end. Concrete headwall on the landside (LS) end. [Additional Reference(s): DWR Levee Log, 2002 (HLM 0.07), listed as a 24-inch corrugated metal pipe [CMP]. USACE San Joaquin O&M Manual, Unit 601 Part 1 (SJR601.1), 1967, Revised 25 May 2011, (HLM 0.07), listed as a 24-inch CMP]  
FS Date: 4/9/2014

Pipe, flapgate, and concrete headwall on WS toe.

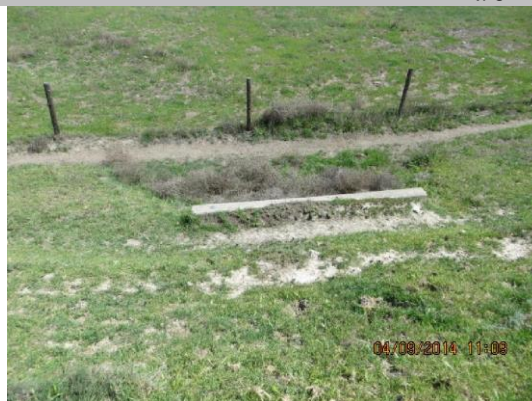
Photo 3 of 3 : UCIP\_SP\_2021\_62422\_60922.jpg

Pipe and concrete headwall on LS toe.

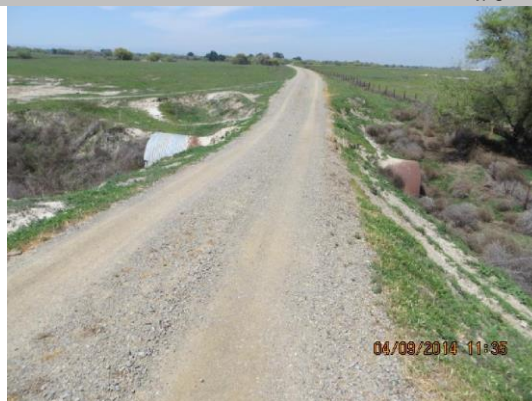
Photo 1 of 3 : UCIP\_SP\_2021\_62420\_71469.jpg

FS\_ID:62420  
DS\_ID:24867  
EP\_NO: N/A  
Repair Type: Urgent  
Crossing Status: Found  
UCIP Comments: 11/01/2018 Same as previous inspection, 1960s levee breach; degraded levee section that drops about 4 feet within a 100-foot levee section. Crossing remains Urgent due to the levee degradation at this location. (O. Magana - DWR UCIP)07/20/2016 same as previous inspection. Levee section at crossing has been degraded. According to LMA representative, Rick, the low point at crossing has been present for over 10 years when the pipe was replaced. (O. Magana - DWR UCIP)04/09/2014 Pipe is open on both ends and levee has been degraded at this location. No permit identified for this crossing. (W. Wylie - DWR UCIP)  
FIELD\_STRUCT\_DESC: 96-inch corrugated metal gravity drainage pipe through the levee, 4.5 feet below the crown. Pipe is composed of two materials: corrugated metal pipe (CMP) on the waterside (WS) and steel pipe on the landside (LS). This section of the levee is a degraded section that drops approximately 4 feet within 100 feet of length. This section of the levee is the site of the 1960s levee breach. [Additional Reference(s): USACE Periodic Inspection Report 2014, USACE\_CESPK\_L05A\_2014\_p\_0014].

Pipe through levee where levee has been degraded.

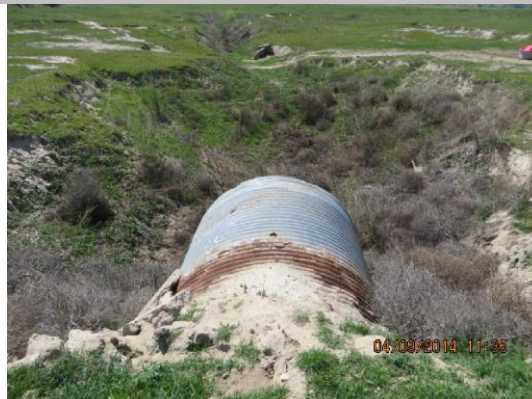
Photo 2 of 3 : UCIP\_SP\_2021\_62420\_71467.jpg

Pipe on WS toe.

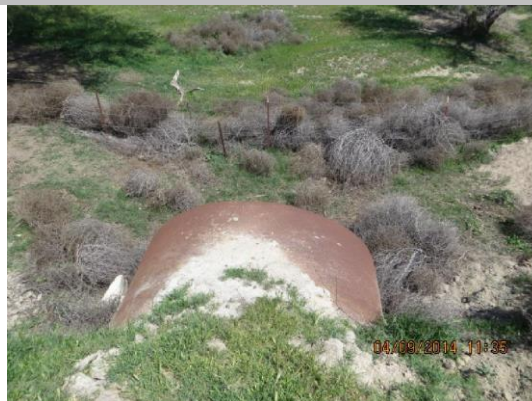
Photo 3 of 3 : UCIP\_SP\_2021\_62420\_71468.jpg

Pipe on LS toe.

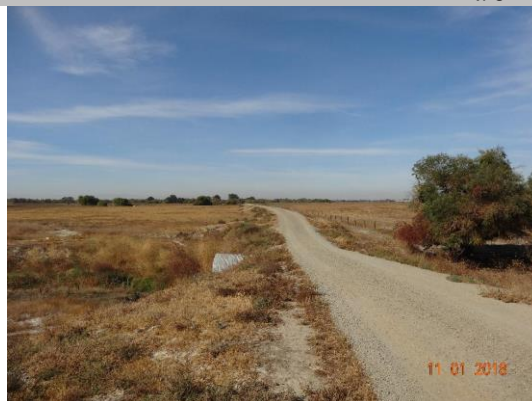
Photo 1 of 3 : UCIP\_SP\_2021\_62423\_78592.jpg

FS\_ID:62423  
DS\_ID:19557  
EP\_NO: N/A  
Repair Type: Non-Urgent  
Crossing Status: Indicator Found  
UCIP Comments: 11/01/2018 24-inch corrugated metal pipe (CMP) section found during pipe inspection of dsid 24867 (see photos); according to LMA representative levee section is the location of levee breach from 1960s; 24-inch pipe was undersized and was replaced after levee breach with a 96-inch CMP and steel pipe. (O. Magana - DWR UCIP)  
FIELD\_STRUCT\_DESC: 24-inch corrugated metal gravity drainage pipe through the levee, 5.6 feet below the crown. Flap gate on the waterside (WS) end. Large pipe found at this location. [Additional Reference(s): USACE San Joaquin O&M Manual, Unit 601 Part 1 (SJR601.1), 1967, Revised 25 May 2011, (HLM 0.30), listed as a 24-inch corrugated metal pipe (CMP)]  
FS Date: 4/9/2014

Overview of degraded levee section.

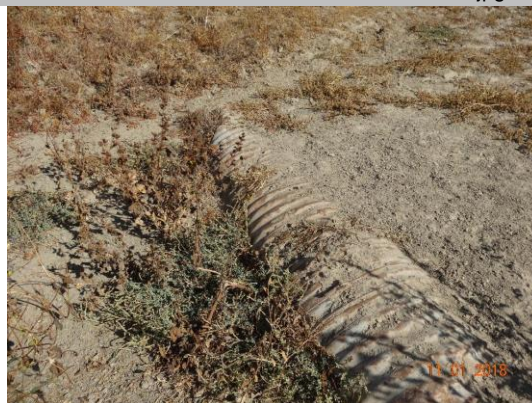
Photo 2 of 3 : UCIP\_SP\_2021\_62423\_78593.jpg

LS view: CMP section found on LS.

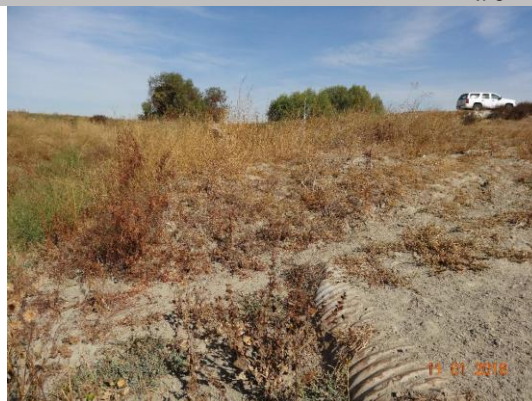
Photo 3 of 3 : UCIP\_SP\_2021\_62423\_78594.jpg

LS view: 24-inch pipe section found west of LS toe.

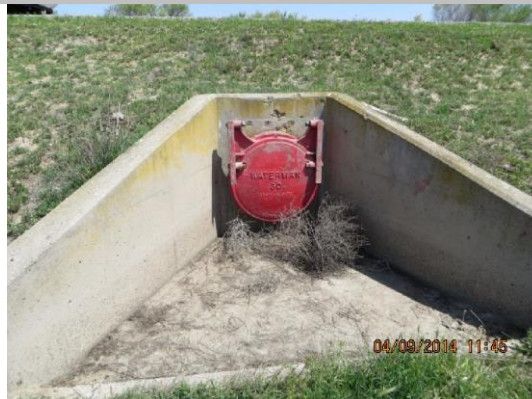
Photo 2 of 3 : UCIP\_SP\_2021\_62424\_60925.jpg

Concrete headwall, pipe, and flapgate on WS toe.

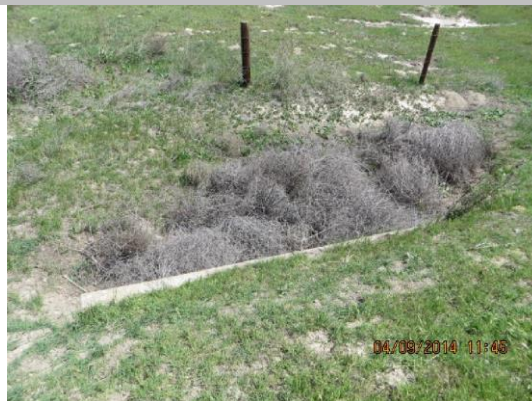
Photo 3 of 3 : UCIP\_SP\_2021\_62424\_60927.jpg

Pipe and concrete headwall on LS toe. Note vegetation buildup.

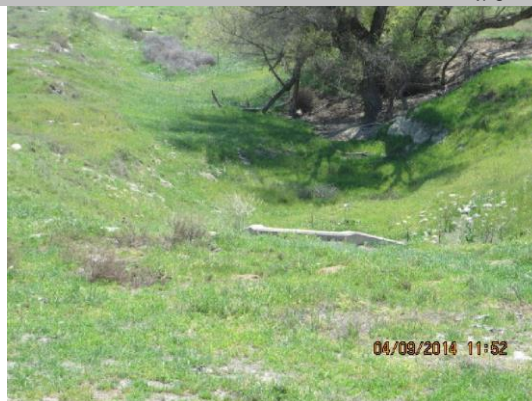
Photo 1 of 3 : UCIP\_SP\_2021\_62519\_60931.jpg

FS\_ID:62519  
DS\_ID:19758  
EP\_NO: N/A  
Repair Type: Non-Urgent  
Crossing Status: Found  
UCIP Comments: 04/09/2014 Dense vegetation limits the inspector's visibility to identify signs of pipe failure (leaks) along the landward slope. Recommend removing vegetation along pipe alignment to conduct proper inspection of structure. (W. Wylie - DWR UCIP)  
FIELD\_STRUCT\_DESC: 36-inch corrugated metal gravity drainage pipe through the levee, 13.2 feet below the crown. Flap gate on the waterside (WS) end. Concrete headwall on the landside (LS) end. Concrete U-shaped headwall on the WS end. Cobble revetment around both ends. [Additional Reference(s): DWR Levee Log, 2002 (HLM 0.64), listed as a 36-inch corrugated metal pipe (CMP). USACE San Joaquin O&M Manual, Unit 601 Part 1 (SJR601.1), 1967, Revised 25 May 2011, (HLM 0.65), listed as a 36-inch CMP].  
FS Date: 4/9/2014

Concrete headwall visible off WS toe.

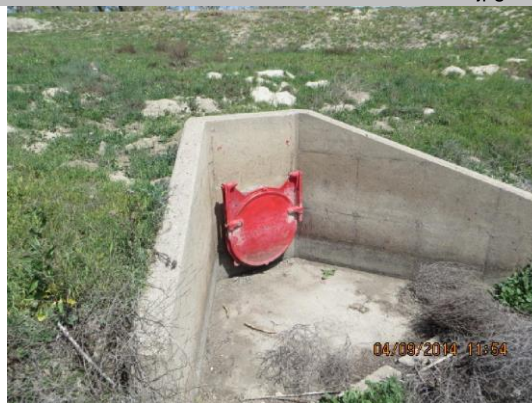
Photo 2 of 3 : UCIP\_SP\_2021\_62519\_60929.jpg

Pipe, flapgate, and headwall at WS toe.

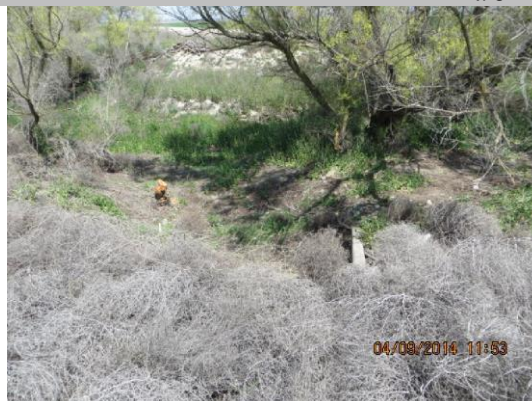
Photo 3 of 3 : UCIP\_SP\_2021\_62519\_60930.jpg

Concrete headwall at LS toe.

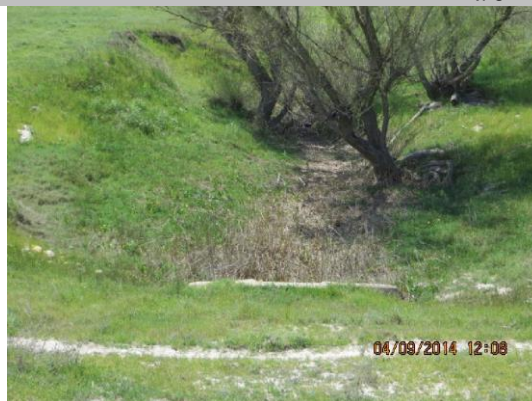
Photo 1 of 3 : UCIP\_SP\_2021\_62425\_60934.jpg

FS\_ID:62425  
 DS\_ID:19759  
 EP\_NO: N/A  
 Repair Type: No Action Needed  
 Crossing Status: Found  
 UCIP Comments:  
 FIELD\_STRUCT\_DESC: 24-inch corrugated metal gravity drainage pipe through the levee, 14.4 feet below the crown. Flap gate on the waterside (WS) end. Concrete headwall on the landside (LS) end. Concrete U-shaped headwall on the WS end. [Additional Reference(s): DWR Levee Log, 2002 (HLM 0.84), listed as a 24-inch corrugated metal pipe (CMP). USACE San Joaquin O&M Manual, Unit 601 Part 1 (SJR601.1), 1967, Revised 25 May 2011, (HLM 0.84), listed as a 24-inch CMP]  
 FS Date: 4/9/2014

Concrete headwall visible at LS toe.

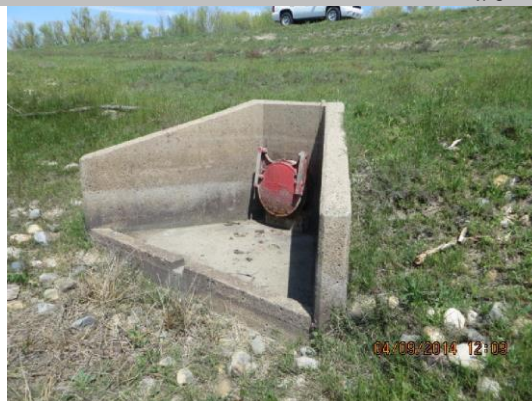
Photo 2 of 3 : UCIP\_SP\_2021\_62425\_60933.jpg

Pipe, flapgate, and headwall at WS toe.

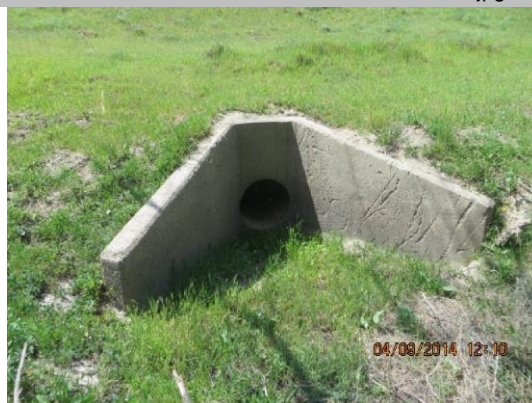
Photo 3 of 3 : UCIP\_SP\_2021\_62425\_60936.jpg

Pipe and concrete headwall at LS toe.

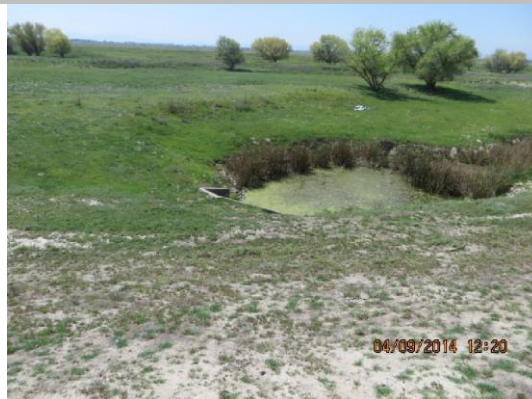
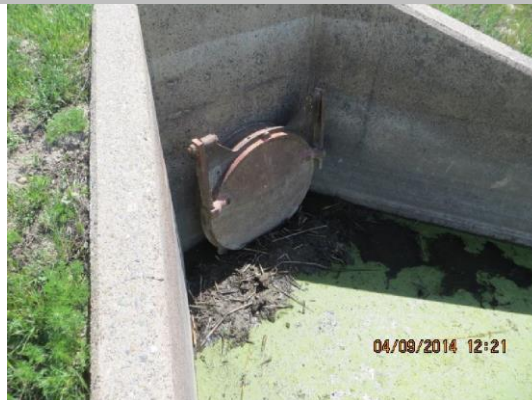
Comment Code					
Inspector Comment					
FS_ID:62426					
DS_ID:19760					
EP_NO: N/A					
Repair Type: No Action Needed					
Crossing Status: Found					
UCIP Comments:					
FIELD_STRUCT_DESC: 36-inch corrugated metal gravity drainage pipe through the levee, 21 feet below the crown. Flap gate on the waterside (WS) end. Concrete headwall on the landside (LS) end. Concrete U-shaped headwall on the WS end. [Additional Reference(s): DWR Levee Log, 2002 (HLM 1.44), listed as a 36-inch corrugated metal pipe (CMP). USACE San Joaquin O&M Manual, Unit 601 Part 1 (SJR601.1), 1967, Revised 25 May 2011, (HLM 1.44), listed as a 36-inch CMP]					
FS Date: 4/9/2014

Flapgate on concrete headwall at WS toe.

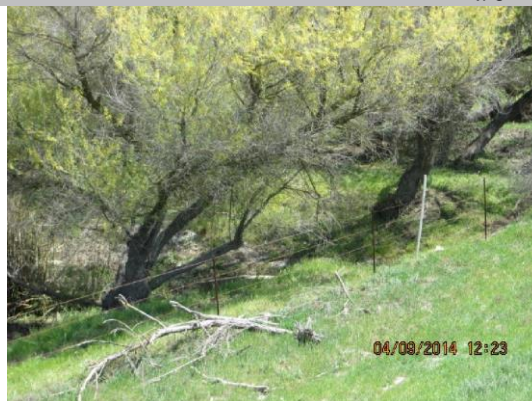
Photo 3 of 3 : UCIP\_SP\_2021\_62426\_60937.jpg

Pipe and concrete headwall on LS toe.

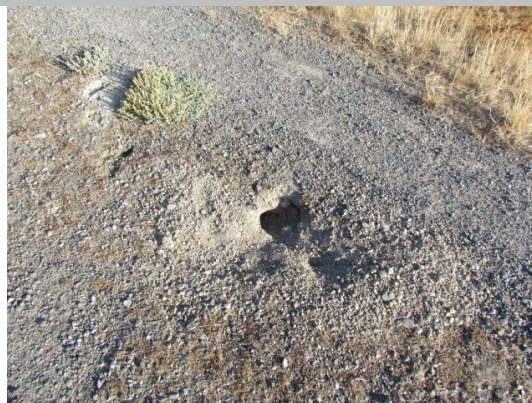
Photo 1 of 1 : SP\_2021\_NA0010\_123\_80\_20210308\_00009.jpg

LM Start	1.66	Rating **	M	Issue No.	80
LM End	1.75	Issue Type +	Ma	Location *	LS
Category	Earthen Levee			GPS Latitude/Longitude	
				Start	End
Item	Animal Control			37.263448 °	37.262225 °
				-120.802715 °	-120.802296 °
DWR ID	DWR_NA0010_05_f_2015_80				
Comment Code					
A3 : No rodents visible, but rodent burrows visible; need to backfill and compact or grout burrows.					
Inspector Comment					
Several rodent holes are located on levee crown and landside slope within this section.

Looking at typical view of rodent holes within this section on landward slope.

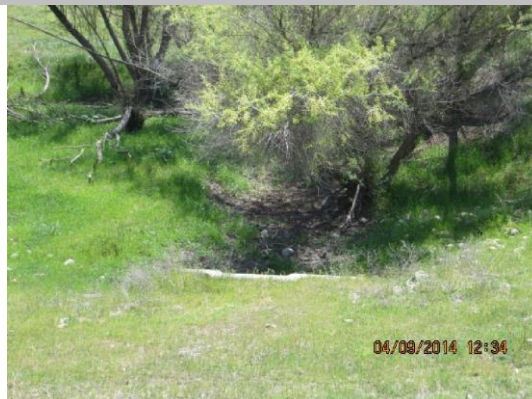
Photo 1 of 3 : UCIP\_SP\_2021\_62427\_60943.jpg

Comment Code						
Inspector Comment						
FS_ID:62427 DS_ID:19809 EP_NO: N/A Repair Type: Non-Urgent Crossing Status: Found UCIP Comments: 04/09/2014 Log partially blocking inlet at LS toe. (W. Wylie - DWR UCIP) FIELD_STRUCT_DESC: 24-inch corrugated metal gravity drainage pipe through the levee, 15 feet below the crown. Flap gate on the waterside (WS) end. Concrete U-shaped headwall on each end. [Additional Reference(s): DWR Levee Log, 2002 (HLM 2.83), listed as a 24-inch corrugated metal pipe (CMP). USACE San Joaquin O&M Manual, Unit 601 Part 1 (SJR601.1), 1967, Revised 25 May 2011, (HLM 2.85), listed as a 24-inch CMP] FS Date: 4/9/2014

Concrete headwall at outlet on WS toe.

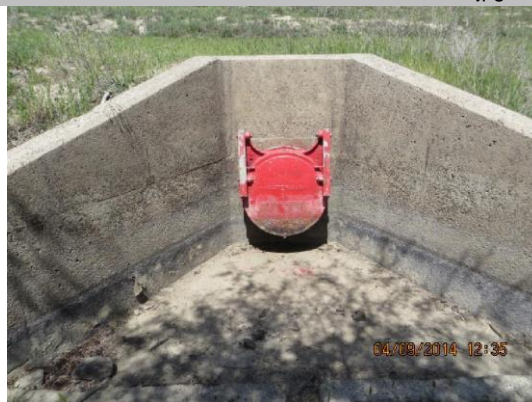
Photo 2 of 3 : UCIP\_SP\_2021\_62427\_60941.jpg

Headwall, pipe, and flapgate on WS toe.

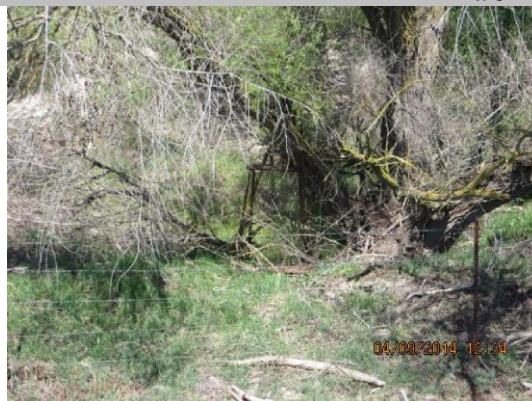
Photo 3 of 3 : UCIP\_SP\_2021\_62427\_60942.jpg

Concrete headwall and metal gate hoist on LS toe.

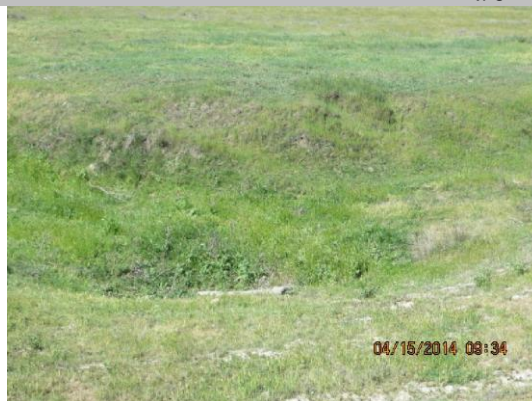
Photo 1 of 3 : UCIP\_SP\_2021\_62421\_60948.jpg

Comment Code						
Inspector Comment						
FS_ID:62421 DS_ID:19810 EP_NO: N/A Repair Type: Non-Urgent Crossing Status: Found UCIP Comments: 04/15/2014 Pipe corroded through at flapgate on WS toe. (W. Wylie - DWR UCIP) FIELD_STRUCT_DESC: 24-inch corrugated metal gravity drainage pipe through the levee, 14.7 feet below the crown. Flap gate on the waterside (WS) end. Concrete U-shaped headwall on each end. [Additional Reference(s): DWR Levee Log, 2002 (HLM 3.36), listed as a 24-inch corrugated metal pipe [CMP]. USACE San Joaquin O&M Manual, Unit 601 Part 1 (SJR601.1), 1967, Revised 25 May 2011, (HLM 3.33), listed as a 24-inch CMP] FS Date: 4/15/2014

Concrete headwall at WS toe.

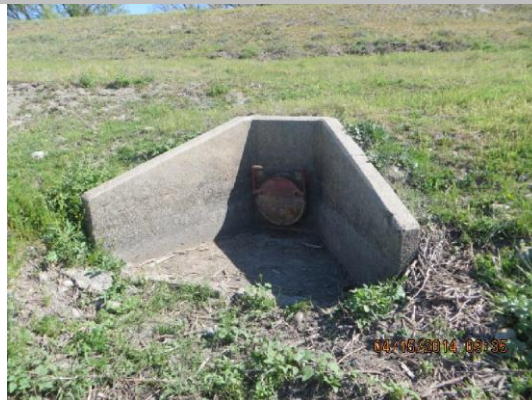
Photo 2 of 3 : UCIP\_SP\_2021\_62421\_60946.jpg

Flapgate and Concrete headwall at WS toe.

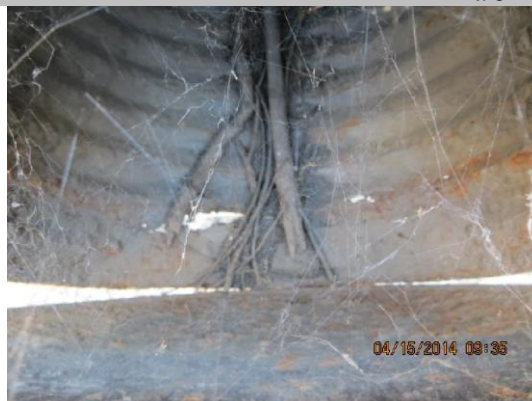
Photo 3 of 3 : UCIP\_SP\_2021\_62421\_60951.jpg

Pipe corroded through just behind flapgate at WS toe.

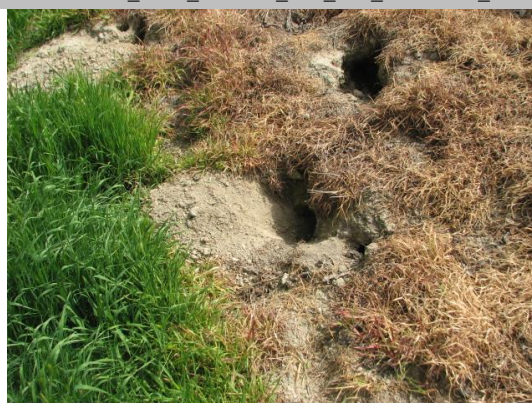
Photo 1 of 1 : SP\_2021\_NA0010\_123\_134\_20210308\_00027.jpg

LM Start	3.55	Rating **	M	Issue No.	134
LM End	3.55	Issue Type +	Ma	Location *	LS
Category	Earthen Levee			GPS Latitude/Longitude	
				Start	End
Item	Animal Control			37.255202 °	37.255202 °
				-120.773655 °	-120.773655 °
DWR ID	DWR_NA0010_05_f _ 2018_134				
Comment Code					
A3 : No rodents visible, but rodent burrows visible; need to backfill and compact or grout burrows.					
Inspector Comment					
Several rodent holes are located within this section.

Looking at typical rodent holes within this section. (Spring 2018)

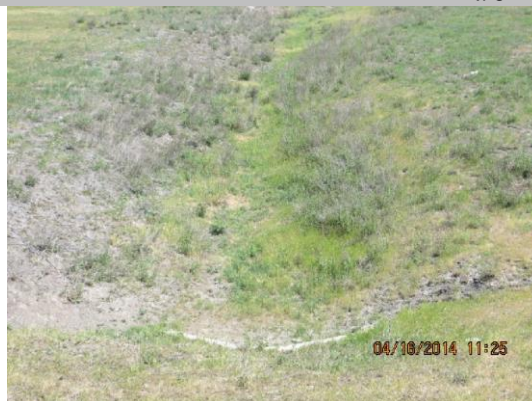
Photo 1 of 3 : UCIP\_SP\_2021\_62430\_61137.jpg

FS\_ID:62430  
DS\_ID:19811  
EP\_NO: N/A  
Repair Type: Non-Urgent  
Crossing Status: Found  
UCIP Comments: 04/16/2014 Sediment buildup in pipe visible from landward side--recommend contacting owner to clear pipe. (W. Wylie - DWR UCIP)  
FIELD\_STRUCT\_DESC: 24-inch corrugated metal gravity drainage pipe through the levee, 15 feet below the crown. Flap gate on the waterside (WS) end. Concrete headwall on the landside (LS) end. Concrete U-shaped headwall on the WS end. [Additional Reference(s): DWR Levee Log, 2002 (HLM 3.67), listed as a 24-inch corrugated metal pipe (CMP). USACE San Joaquin O&M Manual, Unit 601 Part 1 (SJR601.1), 1967, Revised 25 May 2011, (HLM 3.67), listed as a 24-inch CMP]  
FS Date: 4/16/2014

Pipe, headwall, and flapgate on WS toe.

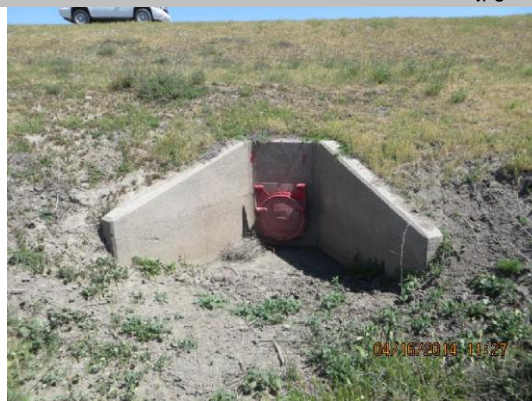
Photo 2 of 3 : UCIP\_SP\_2021\_62430\_61138.jpg

Pipe, headwall, and flapgate on WS toe.

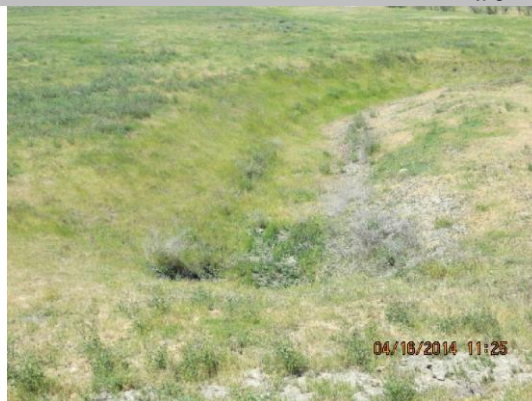
Photo 3 of 3 : UCIP\_SP\_2021\_62430\_61136.jpg

Pipe and headwall on LS toe.

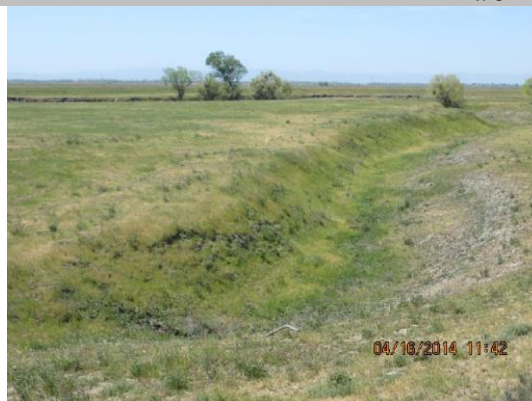
Photo 1 of 3 : UCIP\_SP\_2021\_62431\_61142.jpg

FS\_ID:62431  
 DS\_ID:19769  
 EP\_NO: N/A  
 Repair Type: Non-Urgent  
 Crossing Status: Found  
 UCIP Comments: 04/16/2014 Sediment buildup in pipe visible from landward side--recommend contacting owner to clear pipe. (W. Wylie - DWR UCIP)  
 FIELD\_STRUCT\_DESC: 24-inch corrugated metal gravity drainage pipe through the levee, 16 feet below the crown. Flap gate on the waterside (WS) end. Concrete U-shaped headwall on each end.  
 [Additional Reference(s): DWR Levee Log, 2002 (HLM 4.01), listed as a 24-inch corrugated metal pipe (CMP). USACE San Joaquin O&M Manual, Unit 601 Part 1 (SJR601.1), 1967, Revised 25 May 2011, (HLM 4.02), listed as a 24-inch CMP]  
 FS Date: 4/16/2014

Pipe, headwall, and flapgate on WS toe.
