# Flood Control Project Maintenance Levee Inspections LMA District Cover Sheet

## Lower San Joaquin Levee District

**Flood Control Project Maintenance  
Levee Inspections  
Unit Cover Sheet**

Waterway			Bank	Unit Miles
Unit No. 01 San Joaquin River			Right	22.52
	Spring (March - May)	Summer (June - August)	(September - November) Fall	Winter (December - February)
Unit Maintenance Rating (Fall Only)				
Date of Inspection	5/4/2021 - 5/4/2021			
DWR Inspector	Corey Fujitani			
Accompanied By

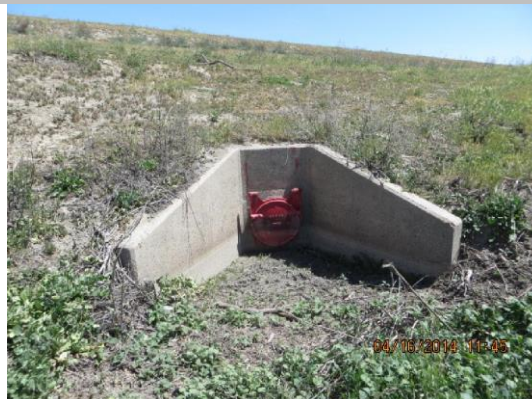
Photo 2 of 3 : UCIP\_SP\_2021\_62431\_61143.jpg

FS\_ID:62431  
 DS\_ID:19769  
 EP\_NO: N/A  
 Repair Type: Non-Urgent  
 Crossing Status: Found  
 UCIP Comments: 04/16/2014 Sediment buildup in pipe visible from landward side--recommend contacting owner to clear pipe. (W. Wylie - DWR UCIP)  
 FIELD\_STRUCT\_DESC: 24-inch corrugated metal gravity drainage pipe through the levee, 16 feet below the crown. Flap gate on the waterside (WS) end. Concrete U-shaped headwall on each end.  
 [Additional Reference(s): DWR Levee Log, 2002 (HLM 4.01), listed as a 24-inch corrugated metal pipe (CMP). USACE San Joaquin O&M Manual, Unit 601 Part 1 (SJR601.1), 1967, Revised 25 May 2011, (HLM 4.02), listed as a 24-inch CMP]  
 FS Date: 4/16/2014

Pipe, headwall, and flapgate on WS toe.

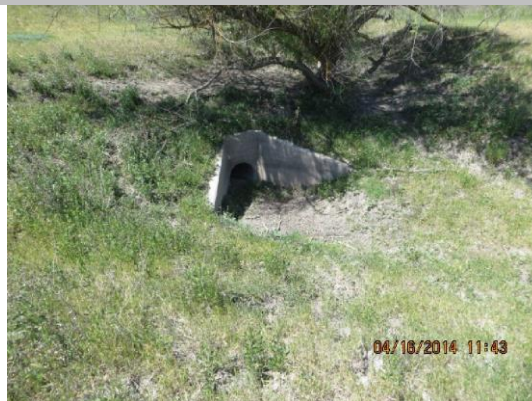
Photo 3 of 3 : UCIP\_SP\_2021\_62431\_61141.jpg

Pipe and headwall on LS toe.

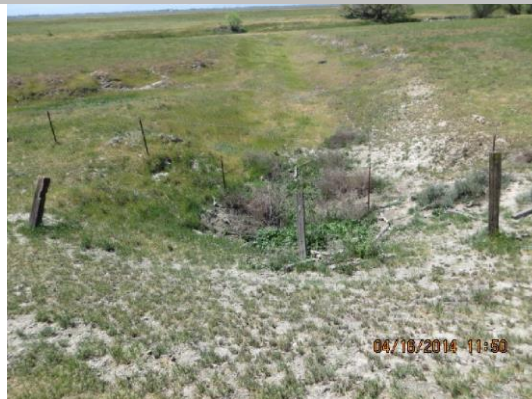
Photo 1 of 3 : UCIP\_SP\_2021\_62432\_61146.jpg

FS\_ID:62432  
DS\_ID:19770  
EP\_NO: N/A  
Repair Type: Non-Urgent  
Crossing Status: Found  
UCIP Comments: 04/16/2014 Sediment buildup in pipe visible from landward side--recommend contacting owner to clear pipe. (W. Wylie - DWR UCIP)  
FIELD\_STRUCT\_DESC: 24-inch corrugated metal gravity drainage pipe through the levee, 11.6 feet below the crown. Flap gate on the waterside (WS) end. Concrete headwall on the landside (LS) end. Concrete U-shaped headwall on the WS end. [Additional Reference(s): DWR Levee Log, 2002 (HLM 4.27), listed as a 24-inch corrugated metal pipe (CMP). USACE San Joaquin O&M Manual, Unit 601 Part 1 (SJR601.1), 1967, Revised 25 May 2011, (HLM 4.27), listed as a 24-inch CMP]  
FS Date: 4/16/2014

Pipe, headwall, and flapgate on WS toe.

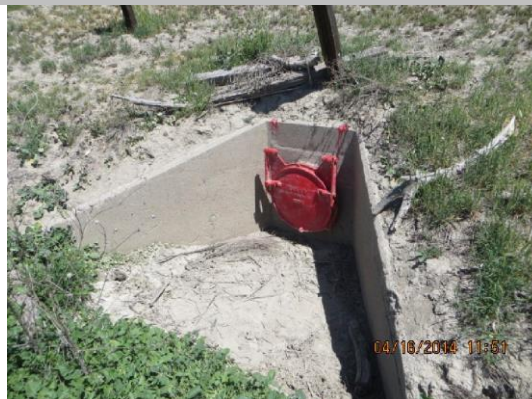
Photo 2 of 3 : UCIP\_SP\_2021\_62432\_61145.jpg

Pipe, headwall, and flapgate on WS toe.

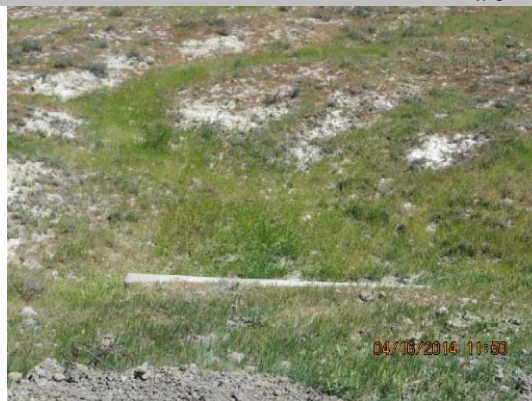
Photo 3 of 3 : UCIP\_SP\_2021\_62432\_61147.jpg

Concrete headwall and pipe on LS toe.

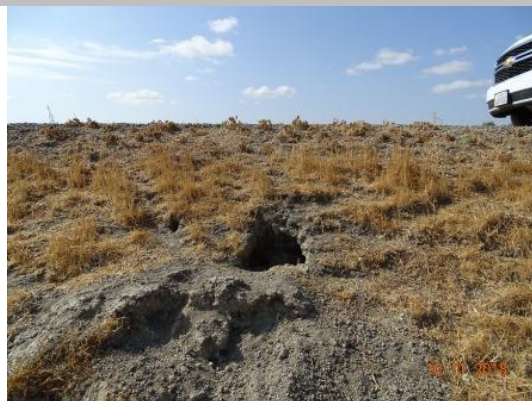
Photo 1 of 1 : SP\_2021\_NA0010\_123\_131\_20210308\_00026.jpg

LM Start	4.33	Rating **	U	Issue No.	131
LM End	4.33	Issue Type +	Ma	Location *	LS
Category	Earthen Levee			GPS Latitude/Longitude	
				Start	End
Item	Animal Control			37.245406 °	37.245406 °
				-120.759971 °	-120.759971 °
DWR ID	DWR_NA0010_05_f _ 2018_131				
Comment Code					
A3 : No rodents visible, but rodent burrows visible; need to backfill and compact or grout burrows.					
Inspector Comment					
Several large rodent holes are located on both sides of levee.

View of a large rodent hole in landward slope. (Fall 2018)

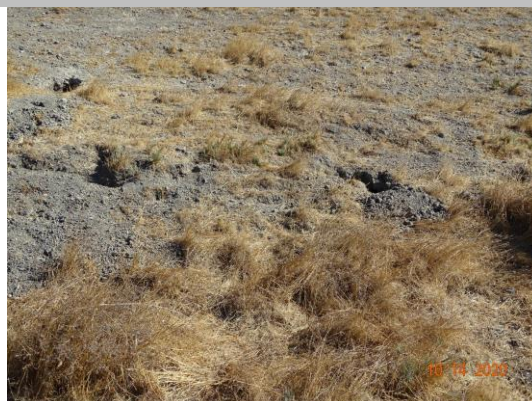
Photo 1 of 1 : SP\_2021\_NA0010\_123\_117\_20210308\_00016.jpg

LM Start	4.33	Rating **	M	Issue No.	117
LM End	4.33	Issue Type +	Ma	Location *	WS
Category	Earthen Levee			GPS Latitude/Longitude	
				Start	End
Item	Animal Control			37.245421 °	37.245421 °
				-120.759943 °	-120.759943 °
DWR ID	DWR_NA0010_05_f_2017_117				
Comment Code					
A1 : Exterminate rodents and backfill and compact or grout burrows.					
Inspector Comment

Several rodent burrows observed at this location. (Fall 2020)

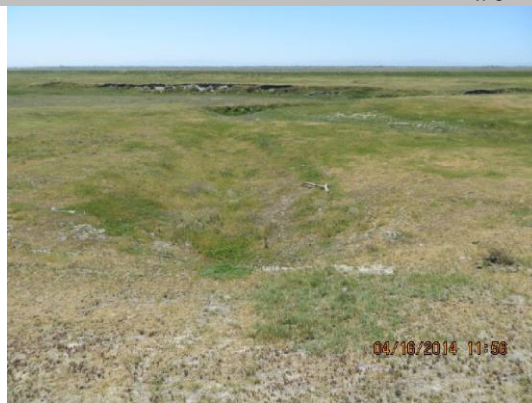
Photo 1 of 3 : UCIP\_SP\_2021\_62433\_62081.jpg

Comment Code					
Inspector Comment					
FS_ID:62433 DS_ID:19771 EP_NO: N/A Repair Type: Non-Urgent Crossing Status: Found UCIP Comments: 04/16/2014 Sediment buildup in pipe visible from landward side--recommend contacting owner to clear pipe. (W. Wylie - DWR UCIP) FIELD_STRUCT_DESC: 24-inch corrugated metal gravity drainage pipe through the levee, 12 feet below the crown. Flap gate on the waterside (WS) end. Concrete headwall on the landside (LS) end. Concrete U-shaped headwall on the WS end. [Additional Reference(s): DWR Levee Log, 2002 (HLM 4.53), listed as a 24-inch corrugated metal pipe (CMP). USACE San Joaquin O&M Manual, Unit 601 Part 1 (SJR601.1), 1967, Revised 25 May 2011, (HLM 4.54), listed as a 24-inch CMP] FS Date: 4/16/2014 8:16:00 AM

Pipe, flapgate, and headwall on WS toe.

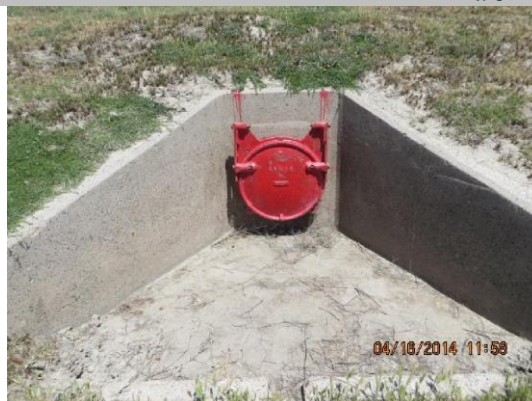
Photo 2 of 3 : UCIP\_SP\_2021\_62433\_62083.jpg

Pipe, flapgate, and headwall on WS toe.

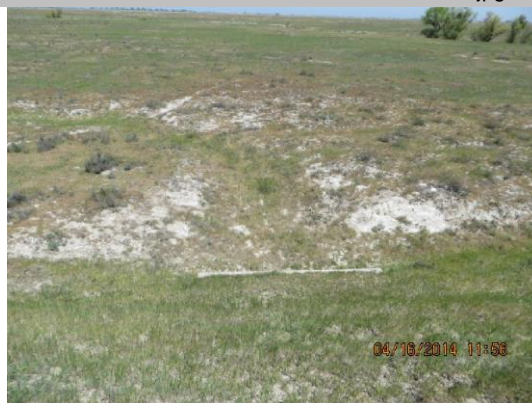
Photo 3 of 3 : UCIP\_SP\_2021\_62433\_62082.jpg

Pipe and headwall on LS toe.

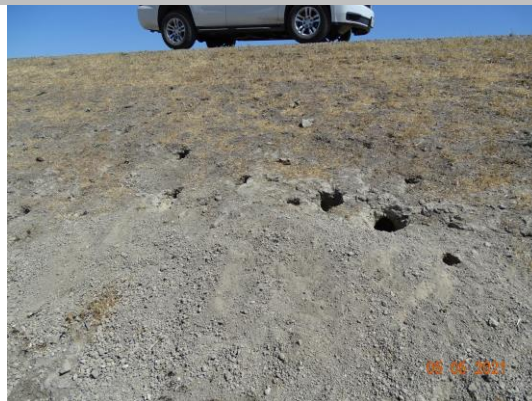
Photo 1 of 1 : SP\_2021\_NA0010\_123\_100\_20210517\_00317.jpg

LM Start	4.85	Rating **	M	Issue No.	100
LM End	4.85	Issue Type +	Ma	Location *	WS
Category	Earthen Levee			GPS Latitude/Longitude	
				Start	End
Item	Animal Control			37.241127 °	37.241127 °
				-120.752398 °	-120.752398 °
DWR ID	DWR_NA0010_05_s_2021_100				
Comment Code					
A1 : Exterminate rodents and backfill and compact or grout burrows.					
Inspector Comment					
Several burrows and rodents observed at this location. Bait stations have been set up.

Several rodent burrows noted at this location. (Spring 2021)

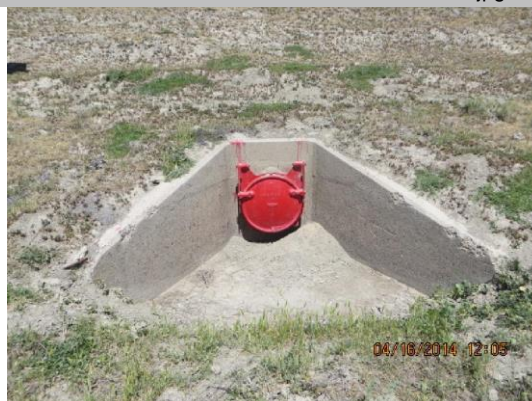
Photo 2 of 3 : UCIP\_SP\_2021\_62434\_62088.jpg

FS\_ID:62434  
DS\_ID:19772  
EP\_NO: N/A  
Repair Type: Non-Urgent  
Crossing Status: Found  
UCIP Comments: 04/16/2014 Heavy sediment buildup in pipe visible from landward side--recommend contacting owner to clear pipe. (W. Wylie - DWR UCIP)  
FIELD\_STRUCT\_DESC: 24-inch corrugated metal gravity drainage pipe through the levee, 12.3 feet below the crown. Flap gate on the waterside (WS) end. Concrete headwall on the landside (LS) end. Concrete U-shaped headwall on the WS end. [Additional Reference(s): DWR Levee Log, 2002 (HLM 4.89), listed as a 24-inch corrugated metal pipe (CMP). USACE San Joaquin O&M Manual, Unit 601 Part 1 (SJR601.1), 1967, Revised 25 May 2011, (HLM 4.89), listed as a 24-inch CMP]  
FS Date: 4/16/2014

Headwall, flapgate, and pipe on WS toe.

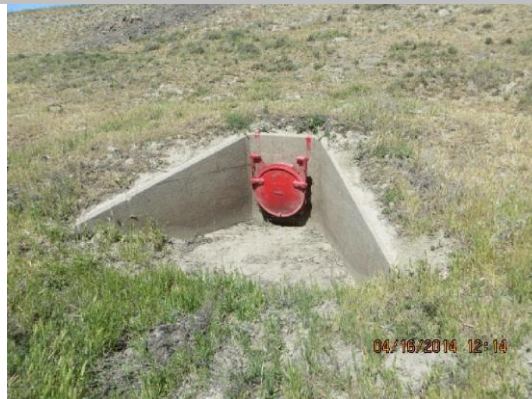
Photo 2 of 3 : UCIP\_SP\_2021\_62435\_62093.jpg

Headwall, flapgate, and pipe on WS toe.

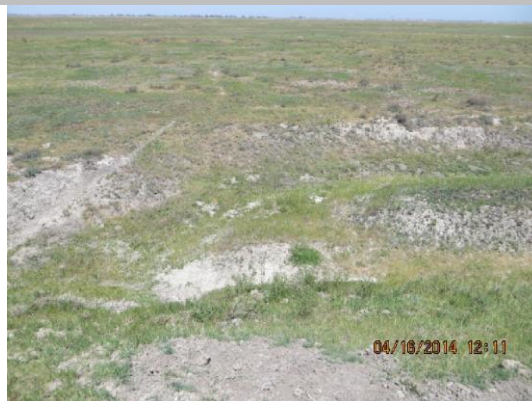
Photo 3 of 3 : UCIP\_SP\_2021\_62435\_62092.jpg

Headwall and pipe on LS toe.

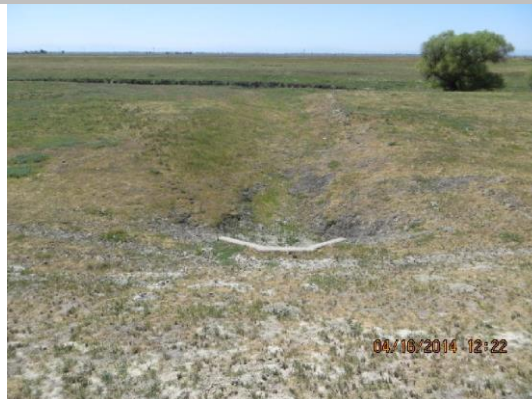
Photo 1 of 3 : UCIP\_SP\_2021\_62436\_62096.jpg

Headwall, flapgate, and pipe on WS toe.

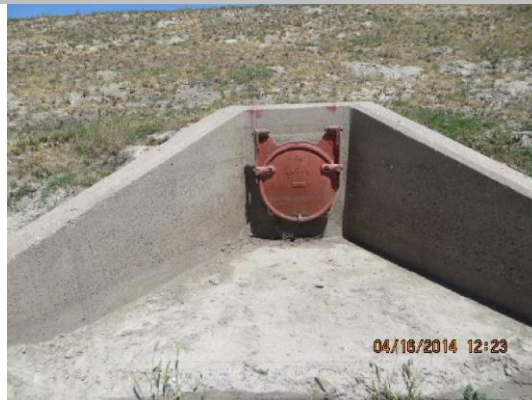
Photo 2 of 3 : UCIP\_SP\_2021\_62436\_62095.jpg

LM Start	5.58	Rating **	A/W	Issue No.	23
LM End	5.58	Issue Type +	Ma	Location *	
Category	Supplemental			GPS Latitude/Longitude	
				Start	End
Item	DWR UCIP LMA Responsibility			37.238879 °	37.238879 °
				-120.739719 °	-120.739719 °
DWR ID	19774				
Comment Code					
Inspector Comment					
FS_ID:62436 DS_ID:19774 EP_NO: N/A Repair Type: No Action Needed Crossing Status: Found UCIP Comments: FIELD_STRUCT_DESC: 24-inch corrugated metal gravity drainage pipe through the levee, 9.5 feet below the crown. Flap gate on the waterside (WS) end. Concrete headwall on the landside (LS) end. Concrete U-shaped headwall on the WS end. [Additional Reference(s): DWR Levee Log, 2002 (HLM 5.58), listed as a 24-inch corrugated metal pipe (CMP). USACE San Joaquin O&M Manual, Unit 601 Part 1 (SJR601.1), 1967, Revised 25 May 2011, (HLM 5.58), listed as a 24-inch CMP] FS Date: 4/16/2014

Headwall, flapgate, and pipe on WS toe.

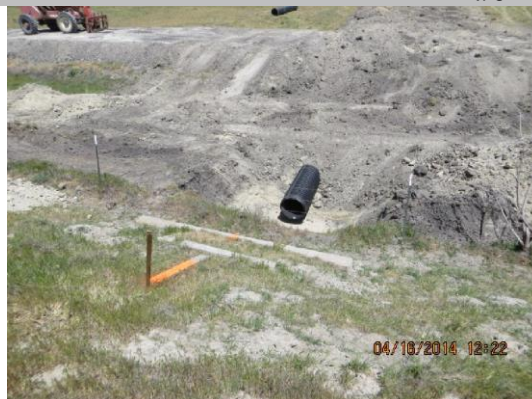
Photo 3 of 3 : UCIP\_SP\_2021\_62436\_62097.jpg

Headwall and pipe on LS toe with HDPE drain pipe being installed off LS toe.

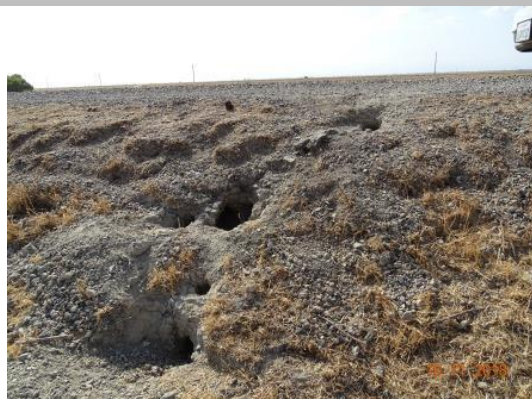
Photo 1 of 1 : SP\_2021\_NA0010\_123\_138\_20210308\_00029.jpg

LM Start	5.94	Rating **	U	Issue No.	138
LM End	5.94	Issue Type +	Ma	Location *	LS
Category	Earthen Levee			GPS Latitude/Longitude	
				Start	End
Item	Animal Control			37.236387 °	37.236387 °
				-120.734164 °	-120.734164 °
DWR ID	DWR_NA0010_05_f_2018_138				
Comment Code					
A1 : Exterminate rodents and backfill and compact or grout burrows.					
Inspector Comment					
Several large rodent holes are located at this location.

View of large rodent holes in landside slope. (Fall 2018)

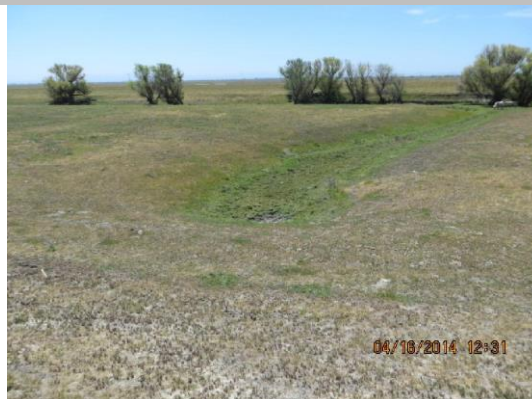
Photo 1 of 3 : UCIP\_SP\_2021\_62437\_62102.jpg

LM Start	6.35	Rating **	A/W	Issue No.	24
LM End	6.35	Issue Type +	Ma	Location *	
Category	Supplemental			GPS Latitude/Longitude	
				Start	End
Item	DWR UCIP LMA Responsibility			37.232589 °	37.232589 °
				-120.728822 °	-120.728822 °
DWR ID	19775				
Comment Code					
Inspector Comment					
FS_ID:62437 DS_ID:19775 EP_NO: N/A Repair Type: No Action Needed Crossing Status: Found UCIP Comments: FIELD_STRUCT_DESC: 24-inch corrugated metal gravity drainage pipe through the levee, 13 feet below the crown. Flap gate on the waterside (WS) end. Concrete headwall on the landside (LS) end. Concrete U-shaped headwall on the WS end. [Additional Reference(s): DWR Levee Log, 2002 (HLM 6.35), listed as a 24-inch corrugated metal pipe (CMP). USACE San Joaquin O&M Manual, Unit 601 Part 1 (SJR601.1), 1967, Revised 25 May 2011, (HLM 6.35), listed as a 24-inch CMP] FS Date: 4/16/2014

Headwall, flapgate, and pipe on WS toe.

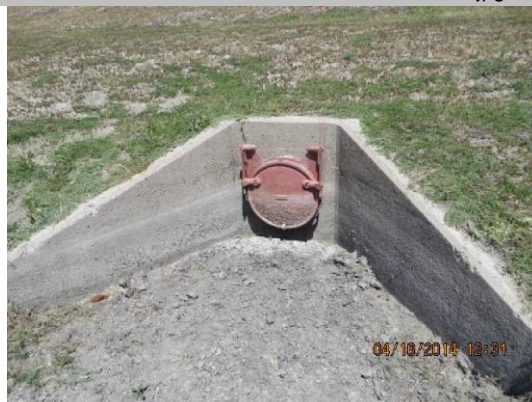
Photo 2 of 3 : UCIP\_SP\_2021\_62437\_62101.jpg

Headwall, flapgate, and pipe on WS toe.

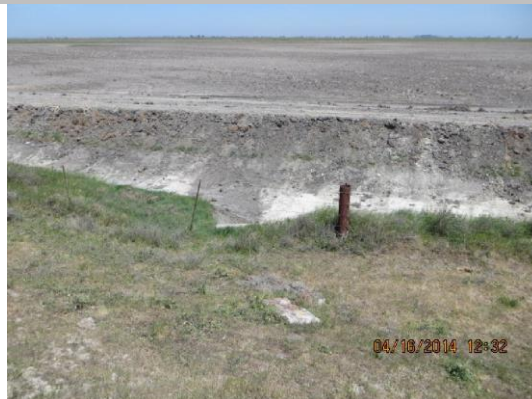
Photo 3 of 3 : UCIP\_SP\_2021\_62437\_62100.jpg

Headwall and pipe on LS toe.

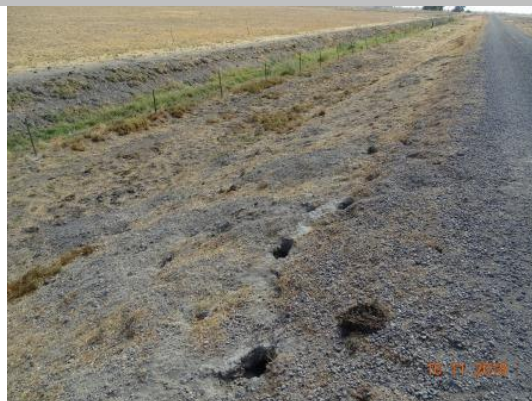
Photo 1 of 1 : SP\_2021\_NA0010\_123\_139\_20210308\_00030.jpg

LM Start	6.40	Rating **	M	Issue No.	139
LM End	6.40	Issue Type +	Ma	Location *	LS
Category	Earthen Levee			GPS Latitude/Longitude	
				Start	End
Item	Animal Control			37.231900 °	37.231900 °
				-120.728345 °	-120.728345 °
DWR ID	DWR_NA0010_05_f_2018_139				
Comment Code					
A1 : Exterminate rodents and backfill and compact or grout burrows.					
Inspector Comment

View of rodent holes on landside shoulder. (Fall 2018)

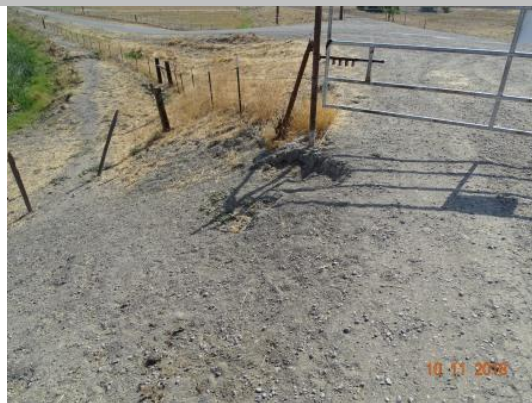
Photo 1 of 1 : SP\_2021\_NA0010\_123\_140\_20210308\_00031.jpg

LM Start	6.56	Rating **	M	Issue No.	140
LM End	6.56	Issue Type +	Ma	Location *	LS
Category	Earthen Levee			GPS Latitude/Longitude	
				Start	End
Item	Animal Control			37.230013 °	37.230013 °
				-120.726832 °	-120.726832 °
DWR ID	DWR_NA0010_05_f _ 2018_140				
Comment Code					
A2 : Repair the levee slope damaged by livestock and prevent large animal access.					
Inspector Comment					
There is erosion on the landward slope near the gate.

Erosion on landward slope caused by foot traffic. (Fall 2018)

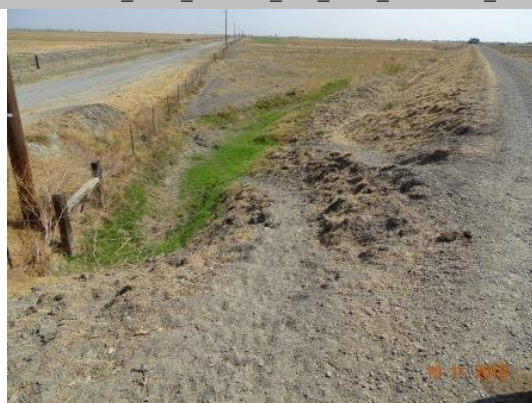
Photo 1 of 1 : SP\_2021\_NA0010\_123\_1309\_20210308\_00051.jpg

LM Start	6.59	Rating **	M	Issue No.	1309
LM End	6.59	Issue Type +	Ma	Location *	LS
Category	Earthen Levee			GPS Latitude/Longitude	
				Start	End
Item	Animal Control			37.229682 °	37.229682 °
				-120.726305 °	-120.726305 °
DWR ID	DWR_NA0010_05_s_2015_1309				
Comment Code					
A2 : Repair the levee slope damaged by livestock and prevent large animal access.					
Inspector Comment					
The landside slope has damage caused by animal foot traffic.

Looking upstream at damaged landside slope. (Fall 2018)

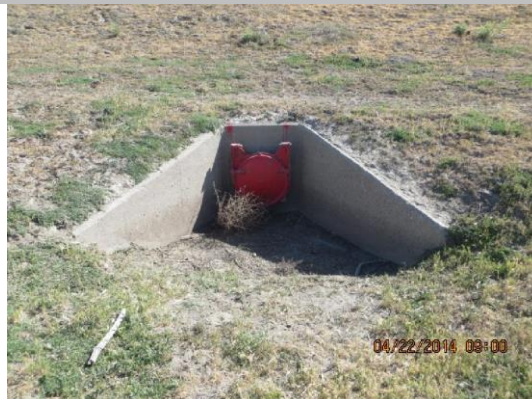
Photo 2 of 3 : UCIP\_SP\_2021\_62428\_62113.jpg

Headwall, flapgate, and pipe on WS toe.

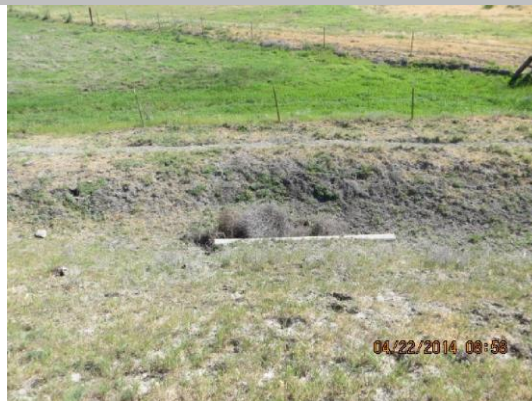
Photo 3 of 3 : UCIP\_SP\_2021\_62428\_62112.jpg

Headwall and pipe on LS toe.

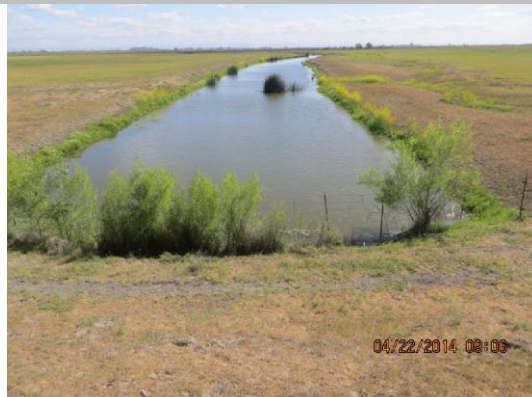
Photo 1 of 2 : UCIP\_SP\_2021\_62429\_62116.jpg

FS\_ID:62429  
DS\_ID:19762  
EP\_NO: N/A  
Repair Type: Non-Urgent  
Crossing Status: Indicator Found  
UCIP Comments: 04/22/2014 Appears abandoned and if so should be done so properly. Slide gate rusted shut on WS slope. Unable to locate inlet or outlet. (W. Wylie - DWR UCIP)  
FIELD\_STRUCT\_DESC: 24-inch corrugated metal gravity drainage pipe through the levee, 20.4 feet below the crown. Slide gate in 36-inch corrugated metal pipe (CMP) riser on the waterside (WS) slope. Concrete U-shaped headwall on each end. Not found in 2014.  
[Additional Reference(s): DWR Levee Log, 2002 (HLM 7.57), listed as a 24-inch corrugated metal pipe (CMP). USACE San Joaquin O&M Manual, Unit 601 Part 1 (SJR601.1), 1967, Revised 25 May 2011, (HLM 7.58), listed as a 24-inch CMP]  
FS Date: 4/22/2014

Likely inlet on LS toe. No pipe or headwall can be seen at current water level.

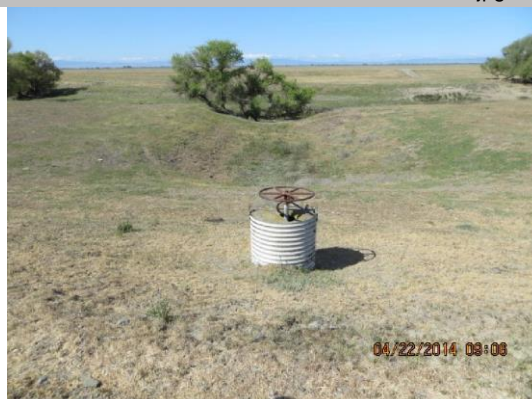
Photo 2 of 2 : UCIP\_SP\_2021\_62429\_62115.jpg

Slide gate in CMP riser on WS slope. No outlet or pipe found on WS toe.

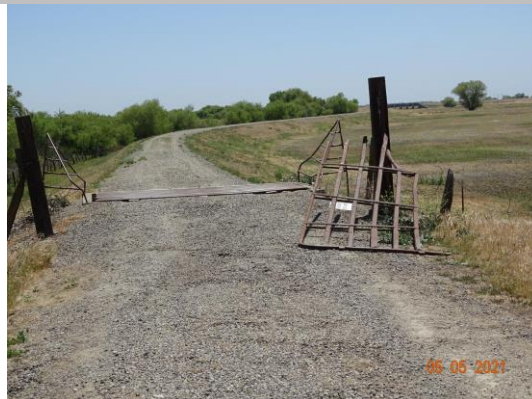
Photo 1 of 1 : SP\_2021\_NA0010\_123\_104\_20210517\_00318.jpg

LM Start	8.09	Rating **	M	Issue No.	104
LM End	8.09	Issue Type +	Ma	Location *	CR
Category	Earthen Levee			GPS Latitude/Longitude	
				Start	End
Item	Repair Gates			37.213580 °	37.213580 °
				-120.706550 °	-120.706550 °
DWR ID	DWR_NA0010_05_s_2017_104				
Comment Code					
Inspector Comment					
The gate has completely broken and should be replaced or removed.

View of gate broken on the waterside shoulder. (Spring 2021)

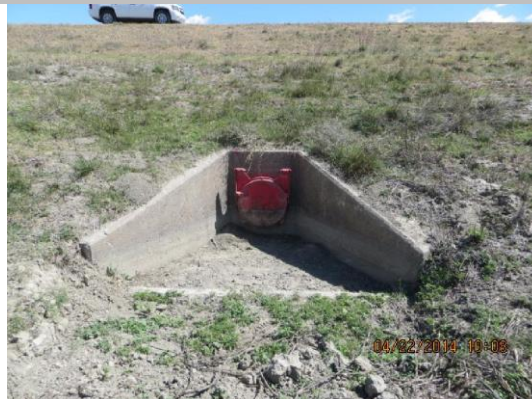
Photo 2 of 3 : UCIP\_SP\_2021\_62451\_62183.jpg

Headwall, flapgate, and pipe on WS toe

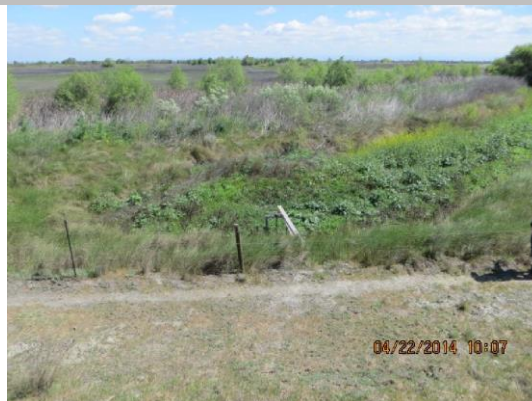
Photo 3 of 3 : UCIP\_SP\_2021\_62451\_62181.jpg

Headwall, slidegate, and pipe on LS toe.

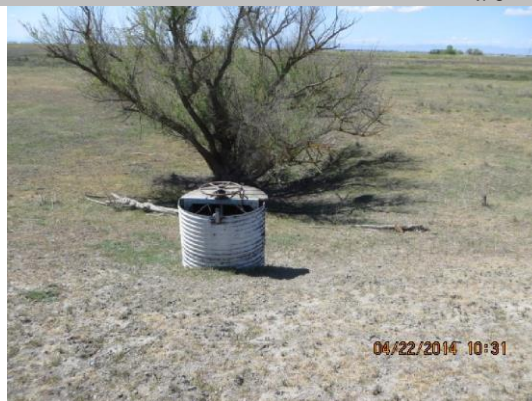
Photo 1 of 3 : UCIP\_SP\_2021\_62455\_62196.jpg

LM Start	9.28	Rating **	A/W	Issue No.	29
LM End	9.28	Issue Type +	Ma	Location *	
Category	Supplemental			GPS Latitude/Longitude	
				Start	End
Item	DWR UCIP LMA Responsibility			37.202742 °	37.202742 °
				-120.690064 °	-120.690064 °
DWR ID	19766				
Comment Code					
Inspector Comment					
FS_ID:62455					
DS_ID:19766					
EP_NO: N/A					
Repair Type: No Action Needed					
Crossing Status: Found					
UCIP Comments:					
FIELD_STRUCT_DESC: 36-inch corrugated metal gravity drainage pipe through the levee, 14.8 feet below the crown. Slide gate in a 48-inch corrugated metal pipe (CMP) riser on the waterside (WS) slope. Concrete headwall on each end. [Additional Reference(s): DWR Levee Log, 2002 (HLM 9.24), listed as a 36-inch CMP. USACE San Joaquin O&M Manual, Part 601 Unit 1 (SJR601.1), 1967, Revised 25 May 2011, (HLM 9.26), listed as a 36-inch CMP]					
FS Date: 4/22/2014

Slide gate in 48-inch CMP riser on WS slope.

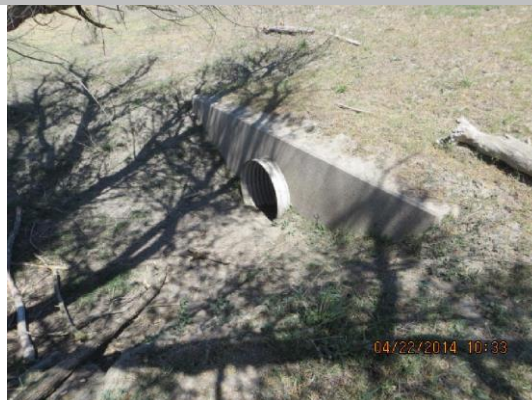
Photo 2 of 3 : UCIP\_SP\_2021\_62455\_62198.jpg

Headwall and pipe at WS toe.

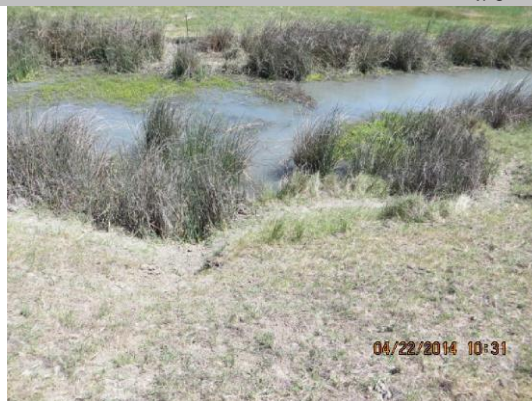
Photo 3 of 3 : UCIP\_SP\_2021\_62455\_62197.jpg

Headwall and pipe at LS toe.

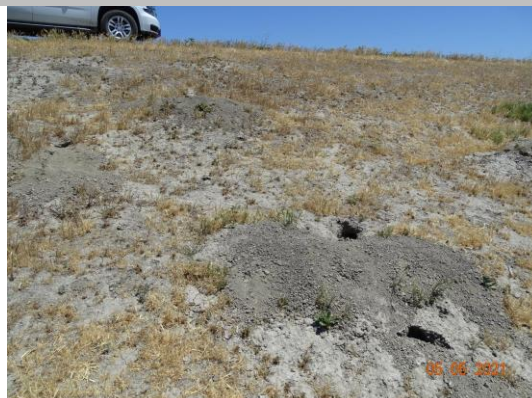
Photo 1 of 1 : SP\_2021\_NA0010\_123\_101\_20210517\_00319.jpg

LM Start	9.45	Rating **	M	Issue No.	101
LM End	9.45	Issue Type +	Ma	Location *	WS
Category	Earthen Levee			GPS Latitude/Longitude	
				Start	End
Item	Animal Control			37.201240 °	37.201240 °
				-120.687686 °	-120.687686 °
DWR ID	DWR_NA0010_05_s_2021_101				
Comment Code					
A3 : No rodents visible, but rodent burrows visible; need to backfill and compact or grout burrows.					
Inspector Comment

Multiple rodent holes in the waterside slope. (Spring 2021)

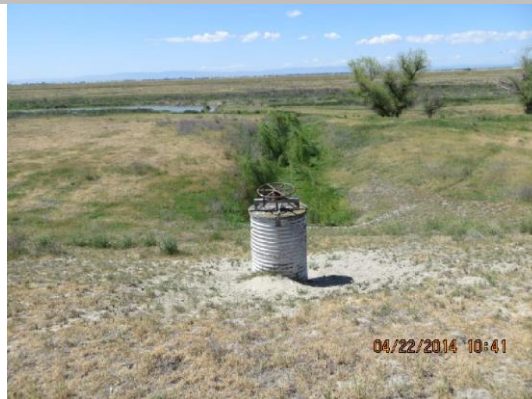
Photo 1 of 3 : UCIP\_SP\_2021\_62456\_62201.jpg

FS\_ID:62456  
DS\_ID:19767  
EP\_NO: N/A  
Repair Type: Non-Urgent  
Crossing Status: Found  
UCIP Comments: 04/22/2014 Slidegate actuator appears bent and may not work properly (WS slope). (W. Wylie - DWR UCIP)  
FIELD\_STRUCT\_DESC: 24-inch corrugated metal gravity drainage pipe through the levee, 15 feet below the crown. Slide gate in a 36-inch corrugated metal pipe (CMP) riser on the waterside (WS) slope. Concrete headwall on each end. [Additional Reference(s): DWR Levee Log, 2002 (HLM 10.04), listed as a 24-inch corrugated metal pipe (CMP). USACE San Joaquin O&M Manual, Unit 601 Part 1 (SJR601.1), 1967, Revised 25 May 2011, (HLM 10.05), listed as a 24-inch CMP].  
FS Date: 4/22/2014

Slidegate in CMP riser on WS slope.

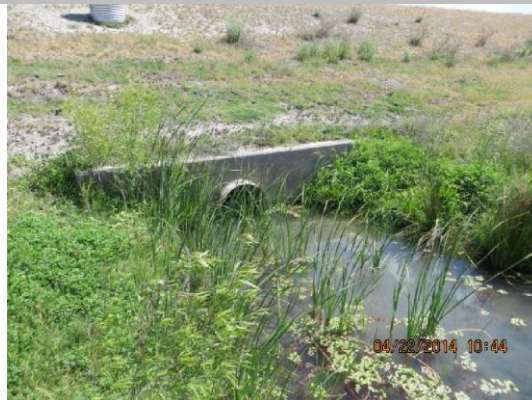
Photo 2 of 3 : UCIP\_SP\_2021\_62456\_62202.jpg

Concrete headwall and pipe on WS toe.

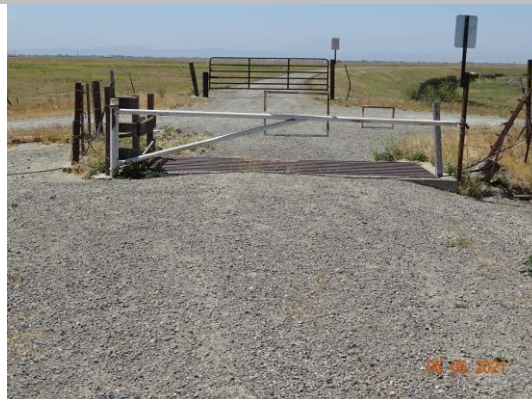
Photo 1 of 1 : SP\_2021\_NA0010\_123\_103\_20210517\_00320.jpg

LM Start	10.69	Rating **	U	Issue No.	103
LM End	10.69	Issue Type +	Ma	Location *	CR
Category	Earthen Levee			GPS Latitude/Longitude	
				Start	End
Item	Repair Gates			37.190302 °	37.190302 °
				-120.670694 °	-120.670694 °
DWR ID	DWR_NA0010_05_s_2021_103				
Comment Code					
Inspector Comment					
Upstream gate at Dan McNamara Rd crossing. District lock appears to have been removed.

Upstream gate no longer has a district lock in the daisy chain. (Spring 2021)

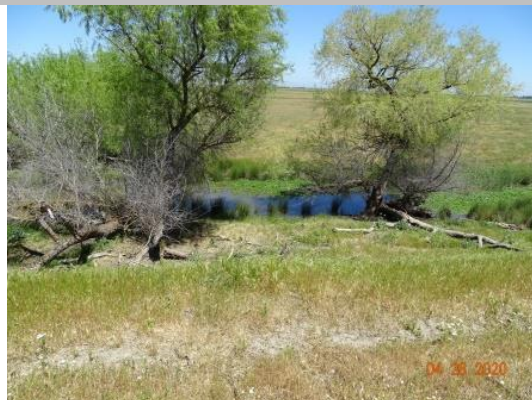
Photo 1 of 1 : SP\_2021\_NA0010\_123\_144\_20210308\_00033.jpg

LM Start	11.37	Rating **	M	Issue No.	144
LM End	11.37	Issue Type +	Ma	Location *	LS
Category	Earthen Levee			GPS Latitude/Longitude	
				Start	End
Item	Trim / Thin Trees			37.187792 °	37.187792 °
				-120.659454 °	-120.659454 °
DWR ID	DWR_NA0010_05_f_2018_144				
Comment Code					
T2 : Thin trees to allow visibility of the ground and room to flood fight.					
Inspector Comment					
Tree limbs on the levee slope should be trimmed to allow access.

View of tree limbs on levee slope. (Spring 2020)

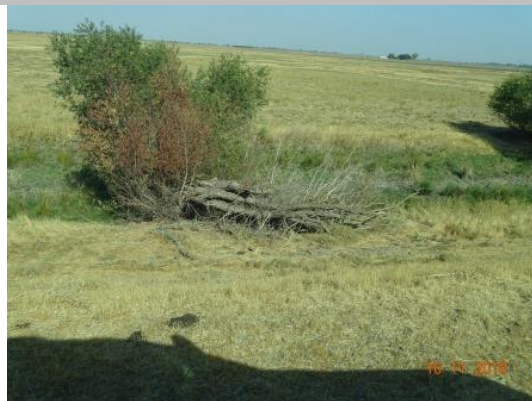
Photo 1 of 1 : SP\_2021\_NA0010\_123\_145\_20210308\_00034.jpg

LM Start	11.41	Rating **	M	Issue No.	145
LM End	11.41	Issue Type +	Ma	Location *	LS
Category	Earthen Levee			GPS Latitude/Longitude	
				Start	End
Item	Trim / Thin Trees			37.187404 °	37.187404 °
				-120.659005 °	-120.659005 °
DWR ID	DWR_NA0010_05_f _ 2018_145				
Comment Code					
T2 : Thin trees to allow visibility of the ground and room to flood fight.					
Inspector Comment					
A fallen tree trunk is located on the levee toe.

Fallen tree on levee toe. (Fall 2018)

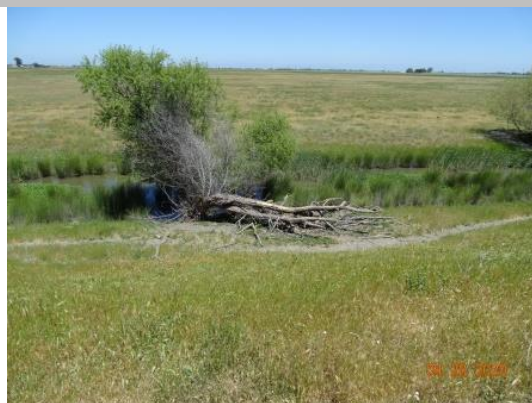
Photo 1 of 1 : SP\_2021\_NA0010\_123\_146\_20210308\_00035.jpg

LM Start	11.44	Rating **	M	Issue No.	146
LM End	11.44	Issue Type +	Ma	Location *	LS
Category	Earthen Levee			GPS Latitude/Longitude	
				Start	End
Item	Trim / Thin Trees			37.187021 °	37.187021 °
				-120.658564 °	-120.658564 °
DWR ID	DWR_NA0010_05_f _ 2018_146				
Comment Code					
T2 : Thin trees to allow visibility of the ground and room to flood fight.					
Inspector Comment					
Fallen tree limbs are located on the levee toe.

Tree limbs and trunk on levee toe. (Spring 2020)

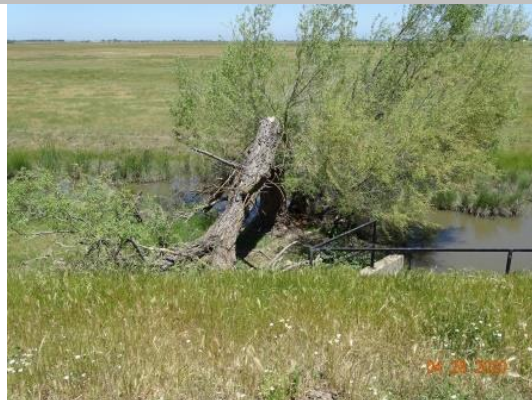
Photo 1 of 1 : SP\_2021\_NA0010\_123\_147\_20210308\_00036.jpg

LM Start	11.49	Rating **	M	Issue No.	147
LM End	11.49	Issue Type +	En	Location *	LS
Category	Earthen Levee			GPS Latitude/Longitude	
				Start	End
Item	Encroachments			37.186482 °	37.186482 °
				-120.657935 °	-120.657935 °
DWR ID	DWR_NA0010_05_f_2018_147				
Comment Code					
TR : Tree or limb					
Inspector Comment					
Tree limbs are located on landside slope and toe.

Tree limbs on levee toe. (Spring 2020)

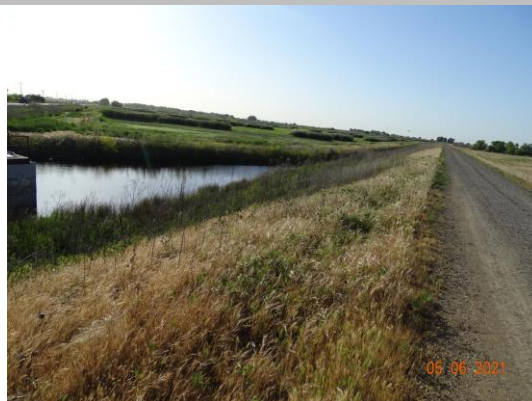
Photo 1 of 1 : SP\_2021\_NA0010\_123\_108\_20210517\_00321.jpg

LM Start	11.55	Rating **	M	Issue No.	108
LM End	13.77	Issue Type +	Ma	Location *	LS
Category	Earthen Levee			GPS Latitude/Longitude	
				Start	End
Item	Vegetation			37.185852 °	37.167627 °
				-120.657196 °	-120.629321 °
DWR ID	DWR_NA0010_05_s_2021_108				
Comment Code					
V1 : Control annual grass and weeds on the levee slopes and easements.					
Inspector Comment

View of vegetation on the landside slope. (Spring 2021)

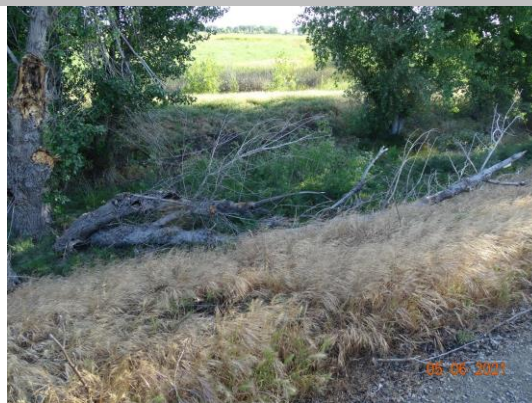
Photo 1 of 1 : SP\_2021\_NA0010\_123\_109\_20210517\_00322.jpg

LM Start	12.82	Rating **	U	Issue No.	109
LM End	12.82	Issue Type +	En	Location *	LS
Category	Earthen Levee			GPS Latitude/Longitude	
				Start	End
Item	Encroachments			37.175814 °	37.175814 °
				-120.642171 °	-120.642171 °
DWR ID	DWR_NA0010_05_s_2021_109				
Comment Code					
TR : Tree or limb					
Inspector Comment

Fallen tree limbs on the landside toe and slope. (Spring 2021)

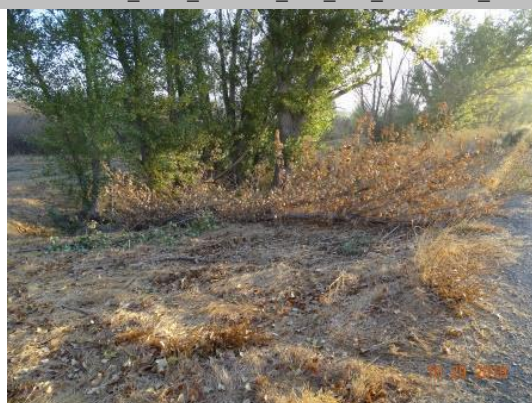
Photo 1 of 1 : SP\_2021\_NA0010\_123\_158\_20210308\_00042.jpg

LM Start	12.88	Rating **	M	Issue No.	158
LM End	12.88	Issue Type +	Ma	Location *	LS
Category	Earthen Levee			GPS Latitude/Longitude	
				Start	End
Item	Encroachments			37.175807 °	37.175807 °
				-120.641139 °	-120.641139 °
DWR ID	DWR_NA0010_05_f _ 2019_158				
Comment Code					
TR : Tree or limb					
Inspector Comment					
Tree limb on the landside slope should be removed.

View of downed tree limb on the landside slope. (Fall 2019)

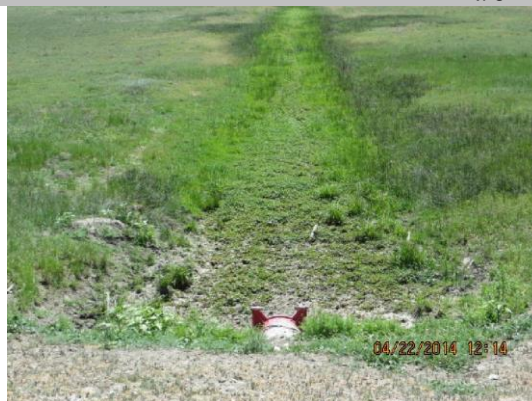
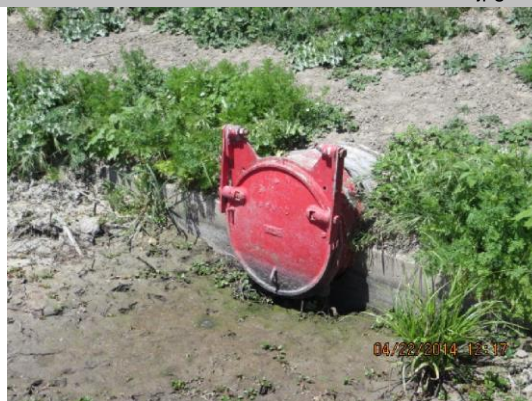
FS\_ID:62462  
DS\_ID:19707  
EP\_NO: N/A  
Repair Type: Non-Urgent  
Crossing Status: Found  
UCIP Comments: 04/22/2014 Sediment buildup in pipe visible from landward side--recommend contacting owner to clear pipe. (W. Wylie - DWR UCIP)  
FIELD\_STRUCT\_DESC: 24-inch corrugated metal gravity drainage pipe through the levee, 10.2 feet below the crown. Concrete headwall on the landside (LS) end with flashboards. Concrete saddle and apron on the waterside (WS) end with a flap gate. Metal screen at LS toe inlet. [Additional Reference(s): DWR Levee Log, 2002 (HLM 12.87), listed as a 24-inch corrugated metal pipe (CMP). USACE San Joaquin O&M Manual, Unit 601 Part 1 (SJR601.1), 1967, Revised 25 May 2011, (HLM 12.87), listed as a 24-inch CMP]  
FS Date: 4/22/2014

Headwall, flapgate, and pipe on WS toe.

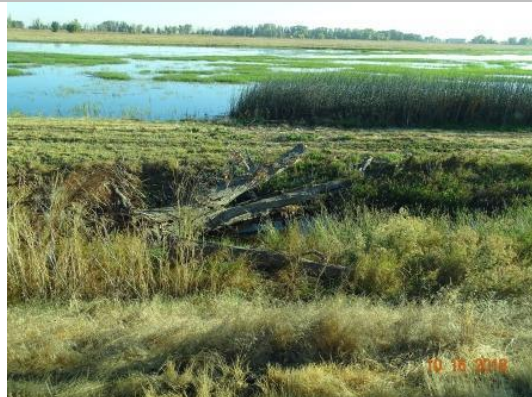
Photo 1 of 1 : SP\_2021\_NA0010\_123\_152\_20210308\_00039.jpg

LM Start	13.15	Rating **	M	Issue No.	152
LM End	13.15	Issue Type +	Ma	Location *	LS
Category	Earthen Levee			GPS Latitude/Longitude	
				Start	End
Item	Encroachments			37.174444 °	37.174444 °
				-120.636589 °	-120.636589 °
DWR ID	DWR_NA0010_05_f_2018_152				
Comment Code					
TR : Tree or limb					
Inspector Comment					
There is a tree trunk on landside toe.

Tree trunk on landside toe. (Fall 2018)

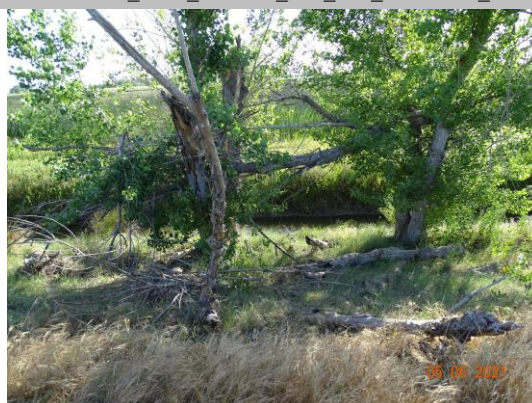
Photo 1 of 1 : SP\_2021\_NA0010\_123\_112\_20210517\_00323.jpg

LM Start	13.37	Rating **	U	Issue No.	112
LM End	13.37	Issue Type +	Ma	Location *	LS
Category	Earthen Levee			GPS Latitude/Longitude	
				Start	End
Item	Encroachments			37.172033 °	37.172033 °
				-120.634005 °	-120.634005 °
DWR ID	DWR_NA0010_05_s_2021_112				
Comment Code					
TR : Tree or limb					
Inspector Comment

View of tree limbs on the landside toe and slope. (Spring 2021)

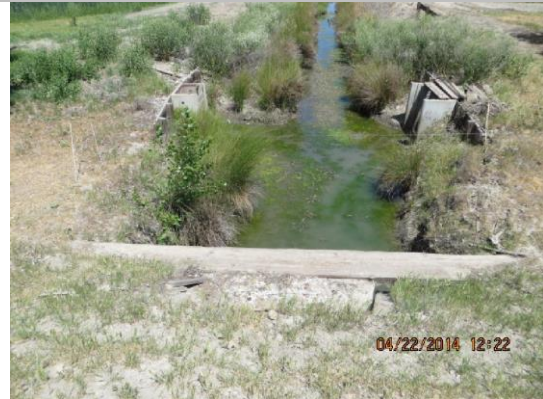
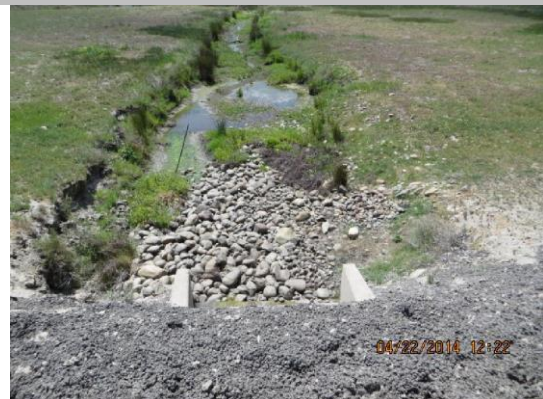
FS\_ID:62463  
DS\_ID:19708  
EP\_NO: N/A  
Repair Type: Non-Urgent  
Crossing Status: Found  
UCIP Comments: 04/22/2014 Some erosion around headwall on the WS toe and there are animal burrows on both slopes. (W. Wylie - DWR UCIP)  
FIELD\_STRUCT\_DESC: 48-inch corrugated metal gravity drainage pipe through the levee, 10 feet below the crown. Flap gate on the waterside (WS) end. Flashboard attachment in concrete U-shaped headwall on the landside (LS) end. Concrete U-shaped headwall on the WS end. [Additional Reference(s): DWR Levee Log, 2002 (HLM 13.40), listed as a 48-inch corrugated metal pipe (CMP). USACE San Joaquin O&M Manual, Unit 601 Part 1 (SJR601.1), 1967, Revised 25 May 2011, (HLM 13.40), listed as a 48-inch CMP].  
FS Date: 4/22/2014

Headwall and pipe on LS toe.

Headwall, flapgate, and pipe on WS toe.

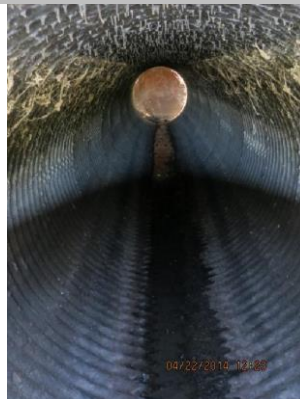
Photo 3 of 3 : UCIP\_SP\_2021\_62463\_62242.jpg

Headwall, flapgate, and pipe on WS toe.

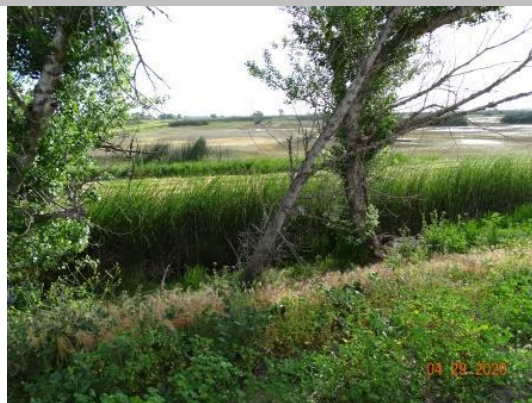
Photo 1 of 1 : SP\_2021\_NA0010\_123\_209\_20210308\_00049.jpg

LM Start	13.44	Rating **	M	Issue No.	209
LM End	13.44	Issue Type +	Ma	Location *	LS
Category	Earthen Levee			GPS Latitude/Longitude	
				Start	End
Item	Encroachments			37.171249 °	37.171249 °
				-120.633157 °	-120.633157 °
DWR ID	DWR_NA0010_05_s_2020_209				
Comment Code					
TR : Tree or limb					
Inspector Comment					
Dead tree should be removed before it can damage the levee.

Dead tree falling over on the landside toe. (Spring 2020)

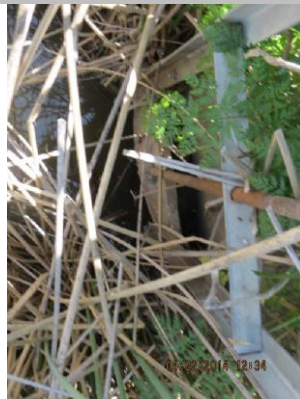
Photo 1 of 2 : UCIP\_SP\_2021\_62520\_62624.jpg

Comment Code						
Inspector Comment						
FS_ID:62520 DS_ID:19709 EP_NO: N/A Repair Type: Non-Urgent Crossing Status: Found UCIP Comments: 04/22/2014 Pipe not visible and may need to have silt removed from outlet on WS toe. (W. Wylie - DWR UCIP) FIELD_STRUCT_DESC: 24-inch corrugated metal gravity drainage pipe through the levee, 10 feet below the crown. Flap gate on the waterside (WS) end. Slide gate on concrete headwall at the landside (LS) toe. Concrete saddle and apron on the WS end. [Additional Reference(s): DWR Levee Log, 2002 (HLM 13.70), listed as a 24-inch corrugated metal pipe (CMP). USACE San Joaquin O&M Manual, Unit 601 Part 1 (SJR601.1), 1967, Revised 25 May 2011, (recorded as HLM 14.72 should be 13.72), listed as a 24-inch CMP] FS Date: 4/22/2014

Slide gate at concrete headwall on LS toe.

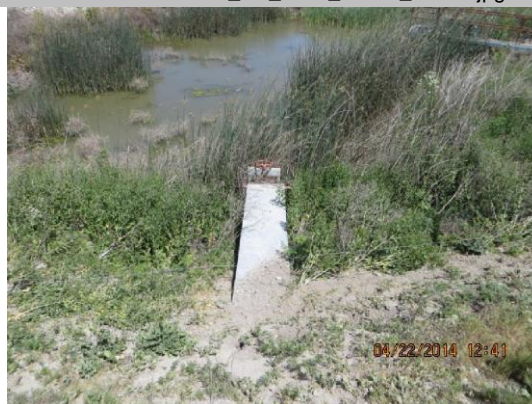
Photo 2 of 2 : UCIP\_SP\_2021\_62520\_62623.jpg

Walkway to gatevalve on LS shoulder.

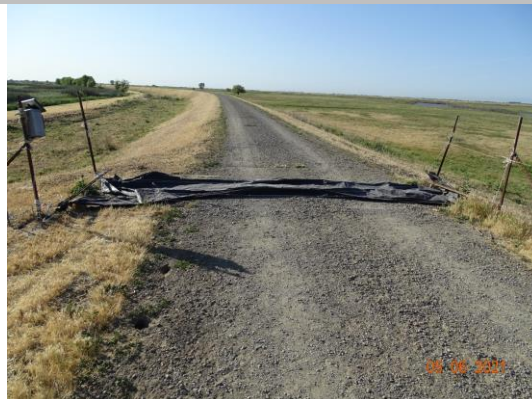
Photo 1 of 1 : SP\_2021\_NA0010\_123\_113\_20210517\_00324.jpg

LM Start	13.76	Rating **	M	Issue No.	113
LM End	13.76	Issue Type +	En	Location *	CR
Category	Earthen Levee			GPS Latitude/Longitude	
				Start	End
Item	Encroachments			37.167787 °	37.167787 °
				-120.629480 °	-120.629480 °
DWR ID	DWR_NA0010_05_s_2021_113				
Comment Code					
FE : Fence					
Inspector Comment					
Landowner has installed temporary livestock fence across levee crown.

View of temporary fence installed by landowner. (Spring 2021)

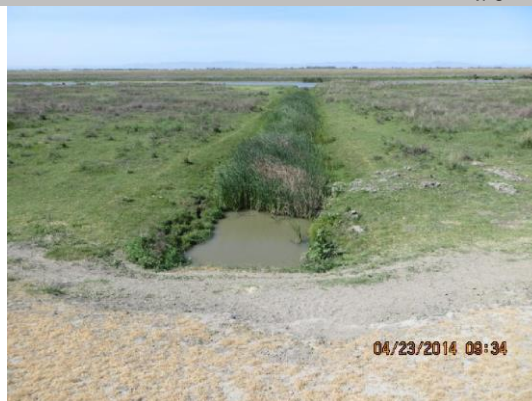
Photo 1 of 3 : UCIP\_SP\_2021\_62438\_62450.jpg

Headwall, flapgate, and pipe on WS toe.

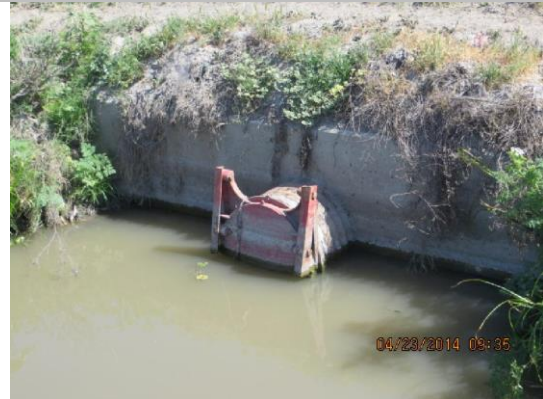
Photo 2 of 3 : UCIP\_SP\_2021\_62438\_62448.jpg

Headwall, flapgate, and pipe on WS toe.

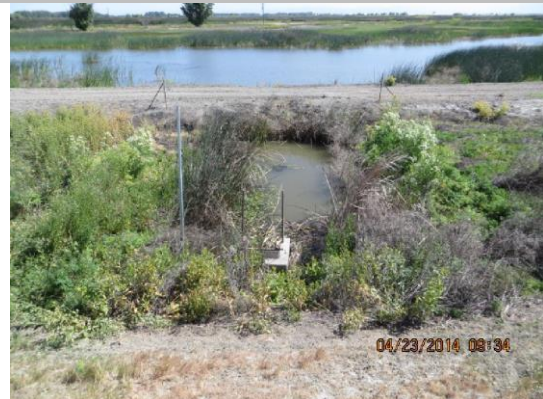
Photo 3 of 3 : UCIP\_SP\_2021\_62438\_62449.jpg

Concrete wier intake structure and pipe at LS toe.

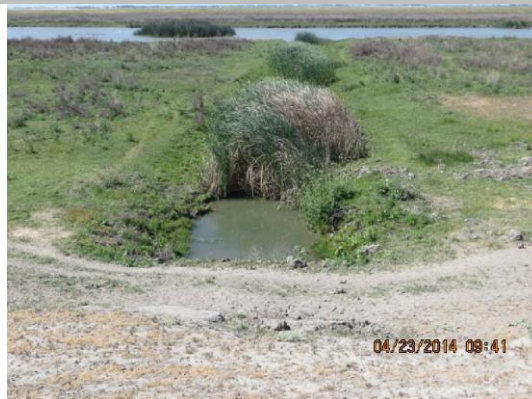
Photo 1 of 3 : UCIP\_SP\_2021\_62439\_62446.jpg

Headwall, pipe, and flapgate on WS toe.

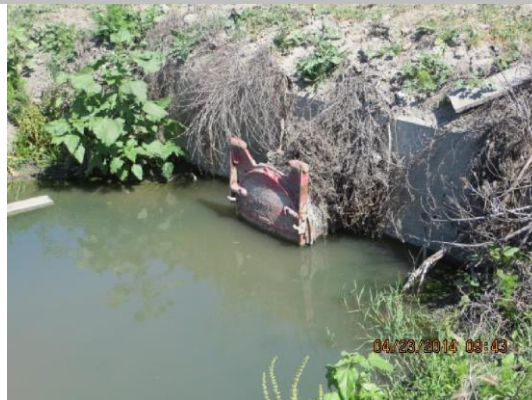
Photo 2 of 3 : UCIP\_SP\_2021\_62439\_62447.jpg

Headwall, pipe, and flapgate on WS toe.

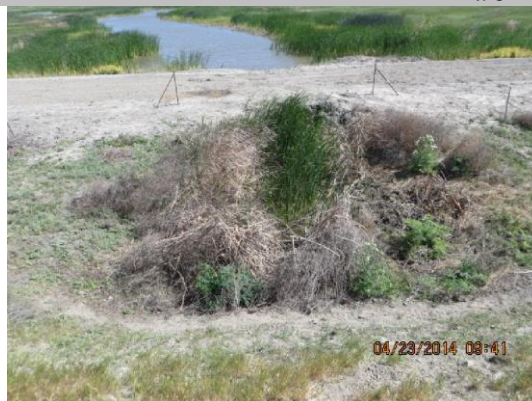
Photo 3 of 3 : UCIP\_SP\_2021\_62439\_62445.jpg

Concrete weir inlet at LS toe.

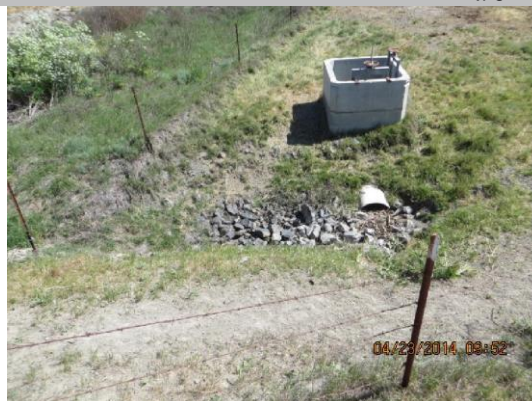
Photo 1 of 3 : UCIP\_SP\_2021\_62440\_62454.jpg

FS\_ID:62440  
DS\_ID:19712  
EP\_NO: N/A  
Repair Type: Non-Urgent  
Crossing Status: Found  
UCIP Comments: 04/23/2014 Minor erosion at headwall on WS toe.  
(W. Wylie - DWR UCIP)  
FIELD\_STRUCT\_DESC: 36-inch corrugated metal gravity drainage pipe through the levee, 11.9 feet below the crown. Flap gate on the waterside (WS) end. Concrete headwall on each end. [Additional Reference(s): DWR Levee Log, 2002 (HLM 15.08), listed as a 36-inch corrugated metal pipe (CMP). USACE San Joaquin O&M Manual, Unit 601 Part 1 (SJR601.1), 1967, Revised 25 May 2011, (HLM 15.09), listed as a 36-inch CMP]  
FS Date: 4/23/2014

Headwall and inlet on LS toe.

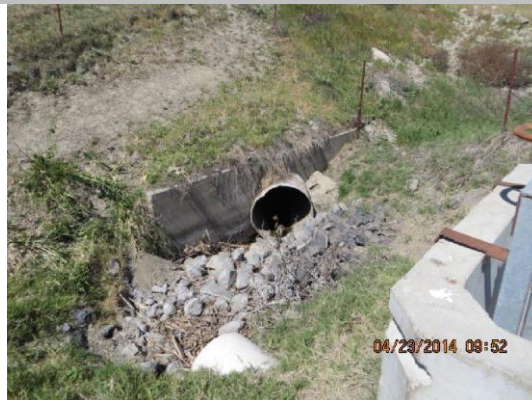
Photo 2 of 3 : UCIP\_SP\_2021\_62440\_62453.jpg

Headwall and inlet on LS toe.

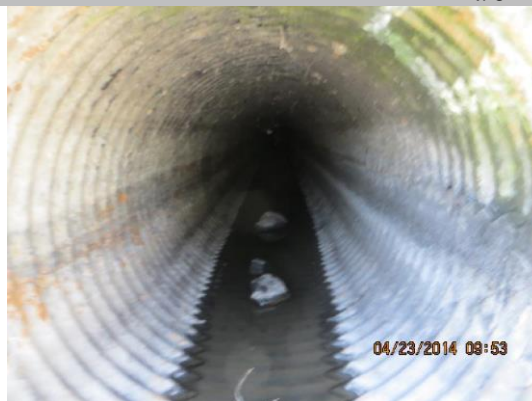
Photo 3 of 3 : UCIP\_SP\_2021\_62440\_62452.jpg

Inside pipe at LS toe.

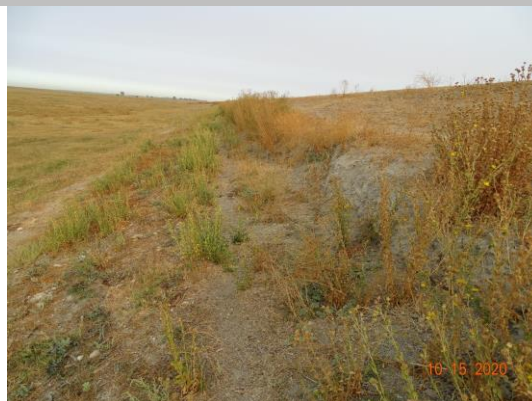
Photo 1 of 1 : SP\_2021\_NA0010\_123\_110\_20210308\_00014.jpg

LM Start	15.21	Rating **	M	Issue No.	110
LM End	15.26	Issue Type +	Ma	Location *	WS
Category	Earthen Levee			GPS Latitude/Longitude	
				Start	End
Item	Erosion / Bank Caving			37.155782 °	37.155337 °
				-120.608075 °	-120.607449 °
DWR ID	DWR_NA0010_05_f_2020_110				
Comment Code					
E1 : Note and monitor erosion site.					
Inspector Comment

Erosion along the waterside slope. (Fall 2020)

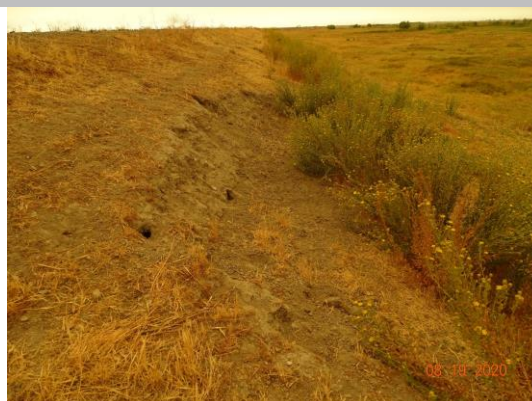
Photo 1 of 2 : SP\_2021\_NA0010\_123\_3\_20210308\_00005.jpg

LM Start	15.31	Rating **	M	Issue No.	3
LM End	15.32	Issue Type +	Ma	Location *	WS
Category	Supplemental			GPS Latitude/Longitude	
				Start	End
Item	DWR Erosion Survey			37.154837 °	37.154837 °
				-120.606737 °	-120.606737 °
DWR ID	NA0010U05RM13.09				
Comment Code					
Inspector Comment					
Site ID: NA0010U05RM13.09 08/19/2020: This site was discovered during the DWR Spring 2020 Levee Inspections. There is a 20-ft long and an 8-ft long erosion pocket, with scarp heights of up to 3 ft. The erosion has cut into the levee prism. There are signs of rodent and cattle activity.

8/19/2020: View of the erosion pocket looking upstream. The erosion has cut into the levee prism.

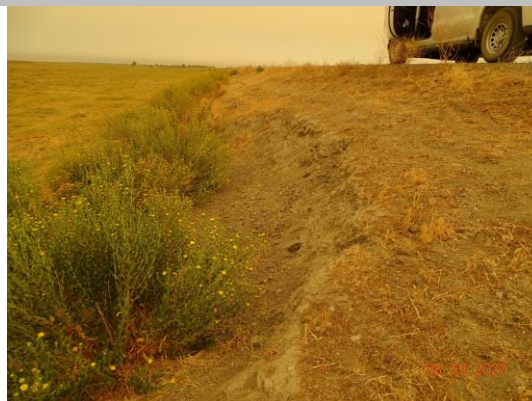
Photo 2 of 2 : SP\_2021\_NA0010\_123\_3\_20210308\_00006.jpg

8/19/2020: Another view of the erosion pocket, looking downstream.

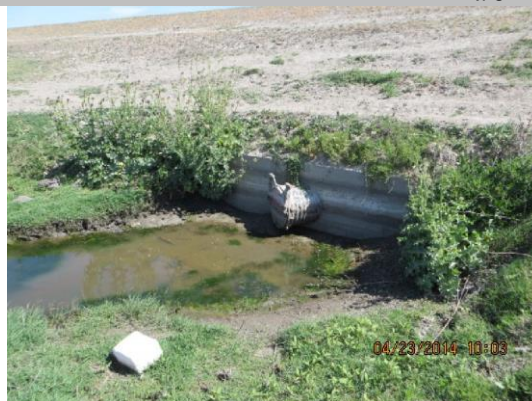
Photo 1 of 3 : UCIP\_SP\_2021\_62441\_62459.jpg

FS\_ID:62441  
DS\_ID:19713  
EP\_NO: N/A  
Repair Type: Non-Urgent  
Crossing Status: Found  
UCIP Comments: 04/23/2014 Sediment buildup in pipe visible from landward side--recommend contacting owner to clear pipe. (W. Wylie - DWR UCIP)  
FIELD\_STRUCT\_DESC: 24-inch corrugated metal gravity drainage pipe through the levee, 11 feet below the crown. Flap gate on the waterside (WS) end. Concrete headwall on each end. [Additional Reference(s): DWR Levee Log, 2002 (HLM 15.74), listed as a 24-inch corrugated metal pipe (CMP). USACE San Joaquin O&M Manual, Unit 601 Part 1 (SJR601.1), 1967, Revised 25 May 2011, (HLM 15.74), listed as a 24-inch CMP]  
FS Date: 4/23/2014

Headwall, pipe, and flapgate on WS toe.

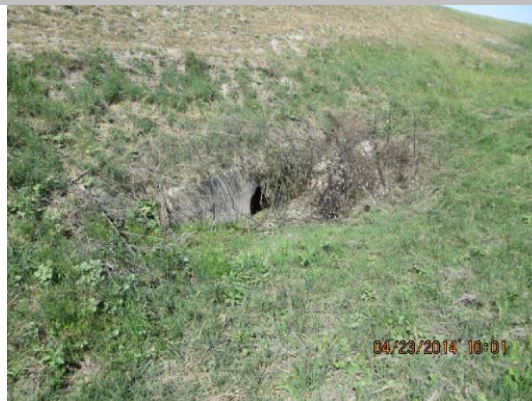
Photo 3 of 3 : UCIP\_SP\_2021\_62441\_62458.jpg

Headwall and pipe at LS toe.

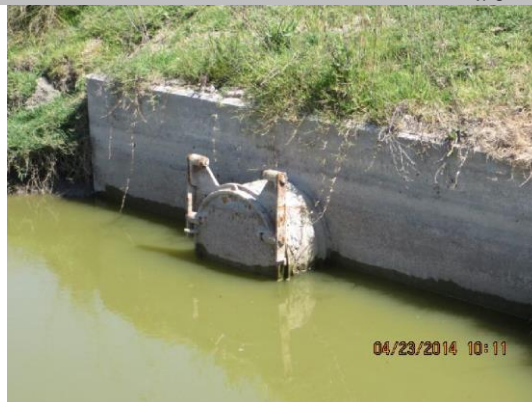
Photo 2 of 3 : UCIP\_SP\_2021\_62443\_62467.jpg

Headwall, pipe, and flapgate on WS toe.
