# Flood Control Project Maintenance Levee Inspections LMA District Cover Sheet

## Lower San Joaquin Levee District

**Flood Control Project Maintenance  
Levee Inspections  
Unit Cover Sheet**

Waterway			Bank	Unit Miles
Unit No. 01 San Joaquin River			Right	22.52
	Spring (March - May)	Summer (June - August)	(September - November) Fall	Winter (December - February)
Unit Maintenance Rating (Fall Only)				
Date of Inspection	5/4/2021 - 5/4/2021			
DWR Inspector	Corey Fujitani			
Accompanied By

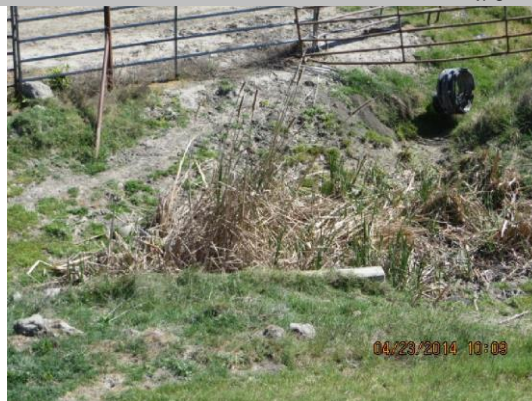
Photo 3 of 3 : UCIP\_SP\_2021\_62443\_62466.jpg

Headwall and pipe visible at LS toe.

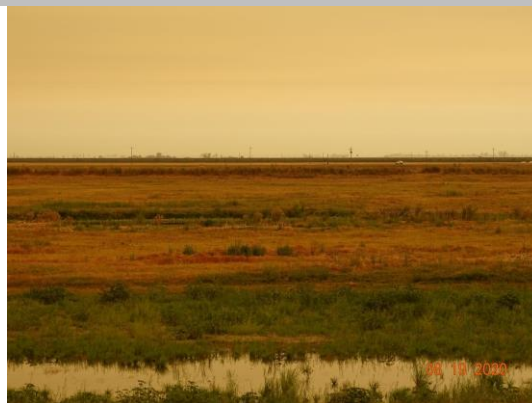
Photo 1 of 3 : SP\_2021\_NA0010\_123\_1\_20210308\_00001.jpg

08/19/2020: Due to ongoing construction both up and downstream, this site could not be accessed and only be viewed from the opposite bank across the bypass. Unable to determine if the conditions changed since the previous inspection.

09/10/2019: The erosion has become worse during the past 2 flood seasons. The erosion length has increased to approximately 200 ft from 55 ft. Signs of animal activity were observed.

09/20/2017: The erosion was discovered during spring levee inspection. The site is covered by dense vegetation and the measurements of the erosion are estimated.

8/19/2020: View of the erosion from across the bypass.

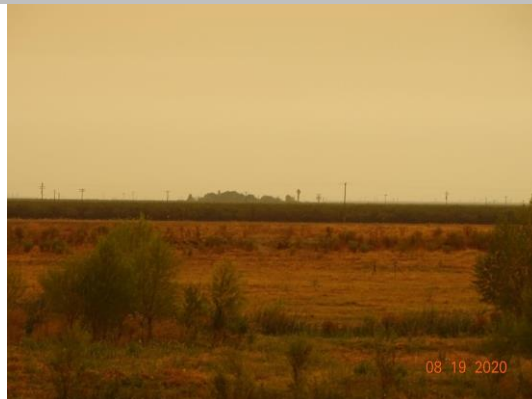
Photo 2 of 3 : SP\_2021\_NA0010\_123\_1\_20210308\_00002.jpg

8/19/2020: Another view of the erosion from across the bypass.

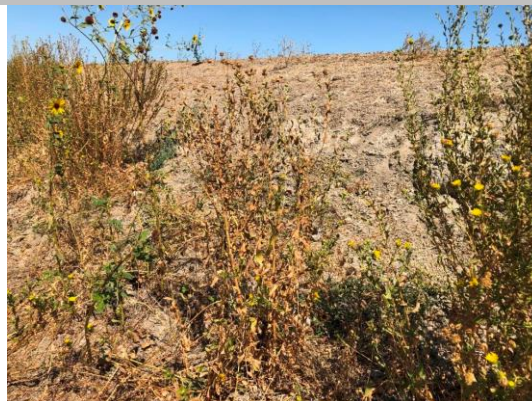
Photo 3 of 3 : SP\_2021\_NA0010\_123\_1\_20210308\_00003.jpg

9/10/2019: Looking at the erosion from the levee toe. Note the dense vegetation.

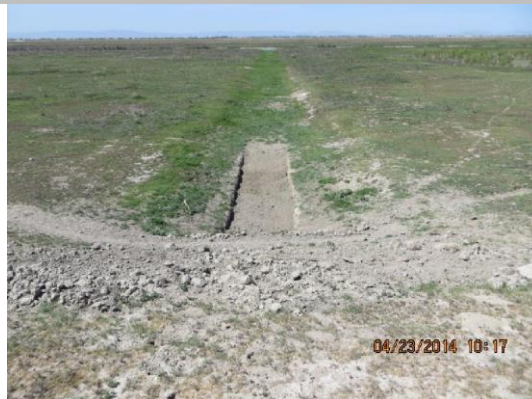
Photo 1 of 3 : UCIP\_SP\_2021\_62444\_62469.jpg

Headwall, flapgate, and pipe visible on WS toe.

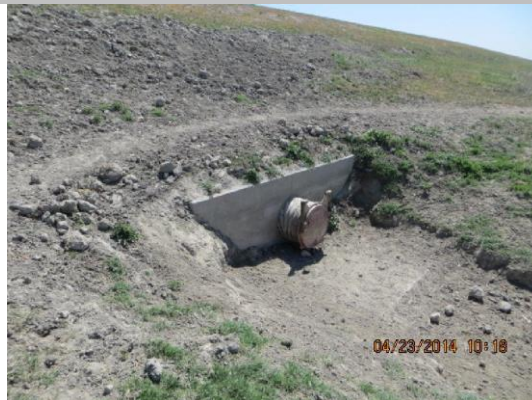
Photo 2 of 3 : UCIP\_SP\_2021\_62444\_62471.jpg

Headwall, flapgate, and pipe visible on WS toe.

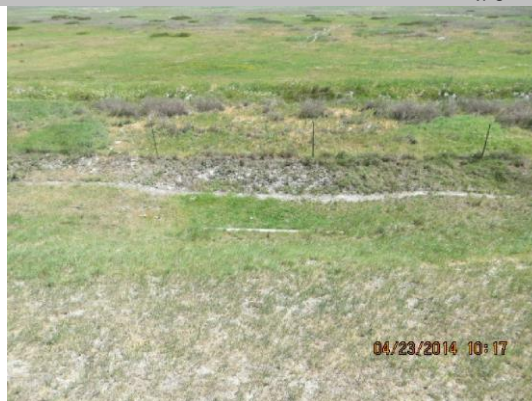
Photo 3 of 3 : UCIP\_SP\_2021\_62444\_62470.jpg

Concrete headwall and pipe visible on LS toe.

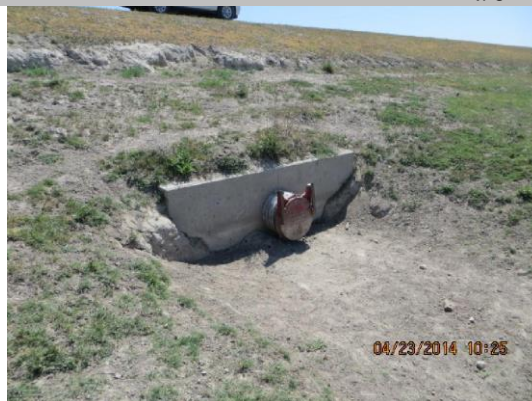
Photo 2 of 3 : UCIP\_SP\_2021\_62445\_62483.jpg

Headwall, flapgate, and pipe visible on WS toe.

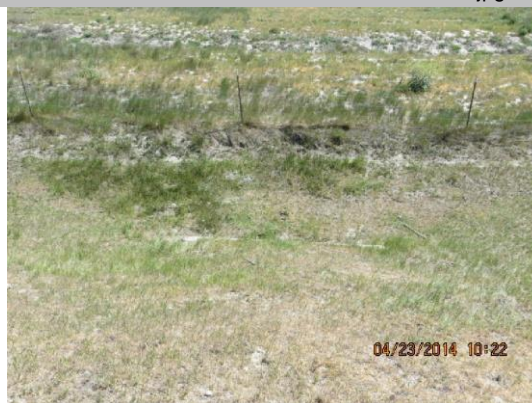
Photo 3 of 3 : UCIP\_SP\_2021\_62445\_62482.jpg

Headwall and pipe visible on LS toe.

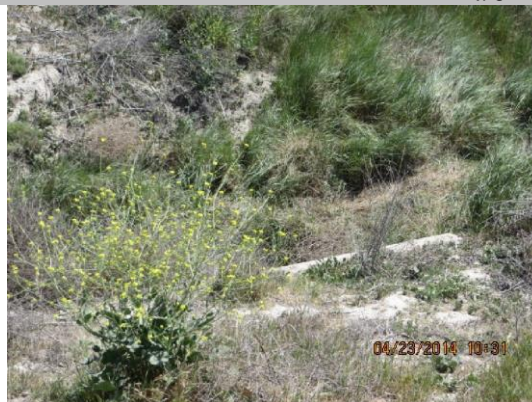
Photo 2 of 3 : UCIP\_SP\_2021\_62446\_62486.jpg

Pipe and headwall visible on LS toe.

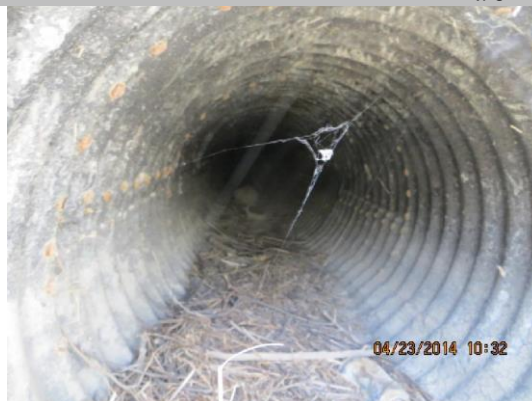
Photo 3 of 3 : UCIP\_SP\_2021\_62446\_62488.jpg

Inside pipe on LS toe.

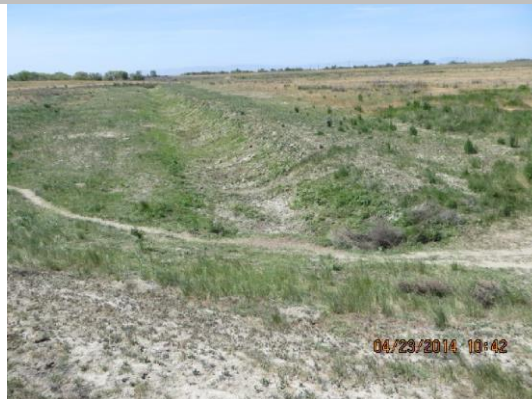
Photo 1 of 3 : UCIP\_SP\_2021\_62465\_62494.jpg

Comment Code						
Inspector Comment						
FS_ID:62465 DS_ID:19745 EP_NO: N/A Repair Type: Non-Urgent Crossing Status: Found UCIP Comments: 04/23/2014 Animal burrows in levee on both slopes. (W. Wylie - DWR UCIP) FIELD_STRUCT_DESC: 24-inch corrugated metal gravity drainage pipe through the levee, 12.4 feet below the crown. Flap gate on the waterside (WS) end. Concrete headwall on each end. [Additional Reference(s): DWR Levee Log, 2002 (HLM 18.07), listed as a 24-inch corrugated metal pipe (CMP). USACE San Joaquin O&M Manual, Unit 601 Part 1 (SJR601.1), 1967, Revised 25 May 2011, (HLM 18.07), listed as a 24-inch CMP] FS Date: 4/23/2014

Headwall, pipe, and flapgate on WS toe.

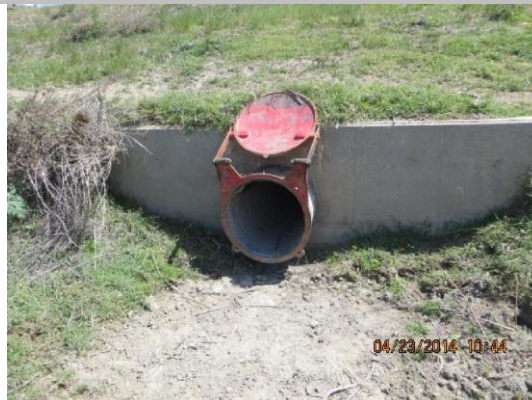
Photo 2 of 3 : UCIP\_SP\_2021\_62465\_62495.jpg

Headwall, pipe, and flapgate on WS toe.

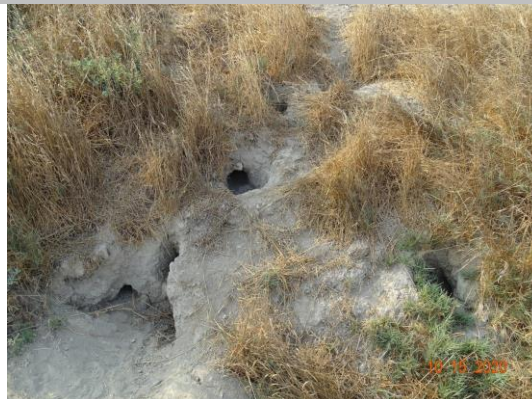
Photo 1 of 1 : SP\_2021\_NA0010\_123\_126\_20210308\_00022.jpg

LM Start	18.62	Rating **	U	Issue No.	126
LM End	18.62	Issue Type +	Ma	Location *	LS
Category	Earthen Levee			GPS Latitude/Longitude	
				Start	End
Item	Animal Control			37.115481 °	37.115481 °
				-120.575126 °	-120.575126 °
DWR ID	DWR_NA0010_05_f _ 2020_126				
Comment Code					
A3 : No rodents visible, but rodent burrows visible; need to backfill and compact or grout burrows.					
Inspector Comment

Several large rodent holes observed at this location. (Fall 2020)

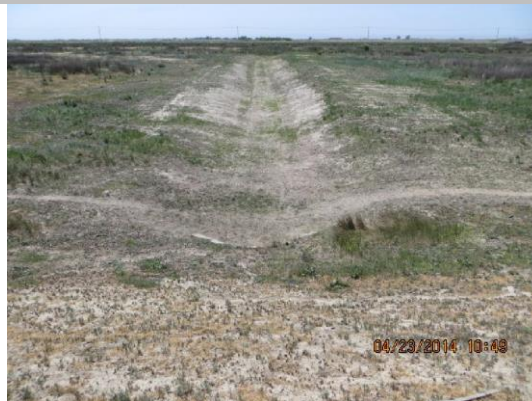
Photo 1 of 3 : UCIP\_SP\_2021\_62466\_62499.jpg

Comment Code					
Inspector Comment					
FS_ID:62466 DS_ID:19746 EP_NO: N/A Repair Type: Non-Urgent Crossing Status: Found UCIP Comments: 04/23/2014 Dense vegetation limits the inspector's visibility to identify signs of pipe failure (leaks) along the landward slope. Recommend removing vegetation along pipe alignment to conduct proper inspection of structure. (W. Wylie - DWR UCIP) FIELD_STRUCT_DESC: 24-inch corrugated metal gravity drainage pipe through the levee, 10 feet below the crown. Flap gate on the waterside (WS) end. Concrete headwall on the landside (LS) end. Concrete U-shaped headwall on the WS end. [Additional Reference(s): DWR Levee Log, 2002 (HLM 18.68), listed as a 24-inch corrugated metal pipe (CMP). USACE San Joaquin O&M Manual, Unit 601 Part 1 (SJR601.1), 1967, Revised 25 May 2011, (HLM 18.68), listed as a 24-inch CMP] FS Date: 4/23/2014

Headwall, pipe and flapgate visible on WS toe.

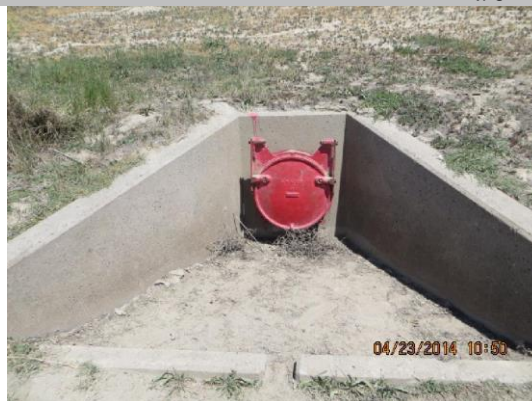
Photo 2 of 3 : UCIP\_SP\_2021\_62466\_62498.jpg

Headwall, pipe and flapgate visible on WS toe.

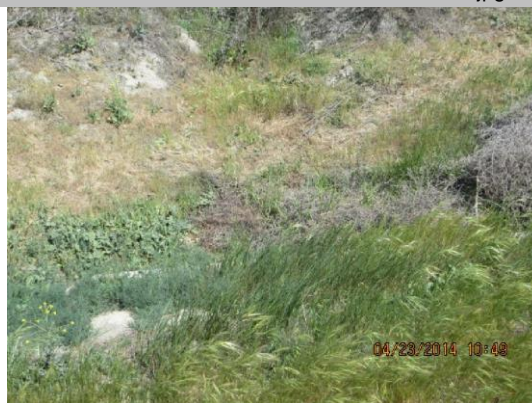
Photo 3 of 3 : UCIP\_SP\_2021\_62466\_62500.jpg

Headwall and pipe on LS toe.

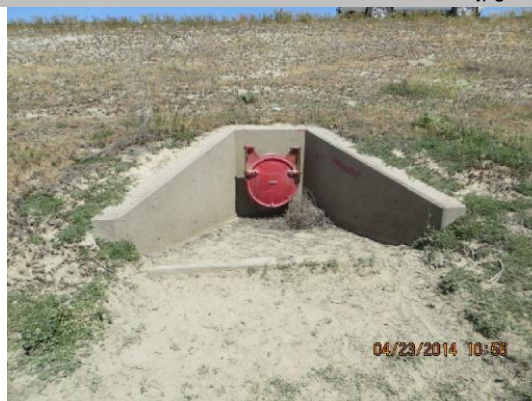
Photo 2 of 3 : UCIP\_SP\_2021\_62467\_62506.jpg

Headwall, pipe, and flapgate visible on WS toe.

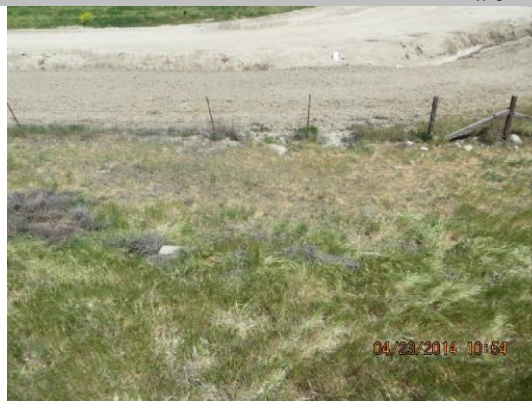
Photo 3 of 3 : UCIP\_SP\_2021\_62467\_62505.jpg

Headwall and pipe visible on LS toe.

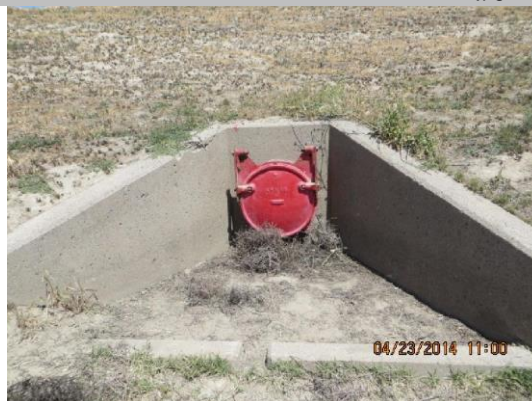
Photo 2 of 3 : UCIP\_SP\_2021\_62468\_62511.jpg

Headwall, pipe, and flapgate visible on WS toe.

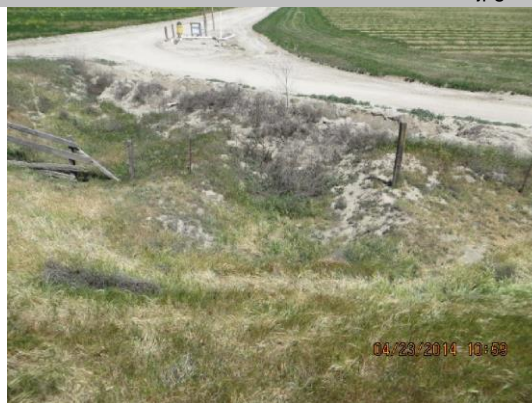
Photo 3 of 3 : UCIP\_SP\_2021\_62468\_62510.jpg

Headwall and pipe visible on LS toe.

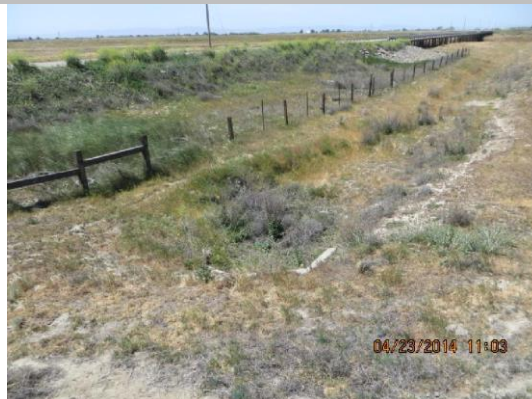
Photo 1 of 3 : UCIP\_SP\_2021\_62469\_62514.jpg

FS\_ID:62469  
DS\_ID:19777  
EP\_NO: N/A  
Repair Type: Non-Urgent  
Crossing Status: Found  
UCIP Comments: 04/23/2014 Sediment buildup in pipe visible from landward side--recommend contacting owner to clear pipe. (W. Wylie - DWR UCIP)  
FIELD\_STRUCT\_DESC: 24-inch corrugated metal gravity drainage pipe through the levee, 9 feet below the crown. Flap gate on the waterside (WS) end. Concrete headwall on the landside (LS) end. Concrete U-shaped headwall on the WS end. [Additional Reference(s): DWR Levee Log, 2002 (HLM 19.46), listed as a 24-inch corrugated metal pipe (CMP). USACE San Joaquin O&M Manual, Unit 601 Part 1 (SJR601.1), 1967, Revised 25 May 2011, (HLM 19.46), listed as a 24-inch CMP]  
FS Date: 4/23/2014

Headwall, pipe, and flapgate visible on WS toe.

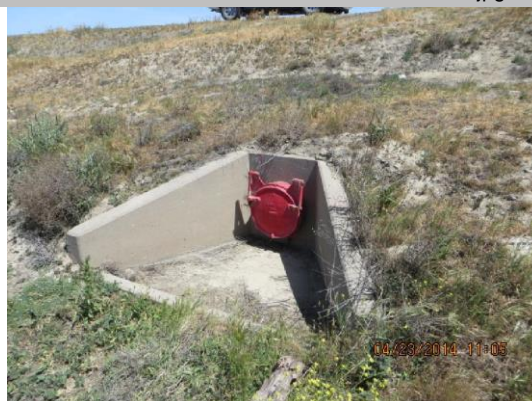
Photo 2 of 3 : UCIP\_SP\_2021\_62469\_62516.jpg

Headwall, pipe, and flapgate visible on WS toe.

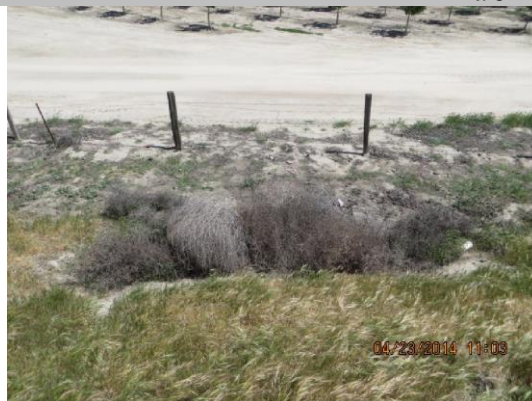
Photo 3 of 3 : UCIP\_SP\_2021\_62469\_62515.jpg

Headwall and pipe visible on LS toe.

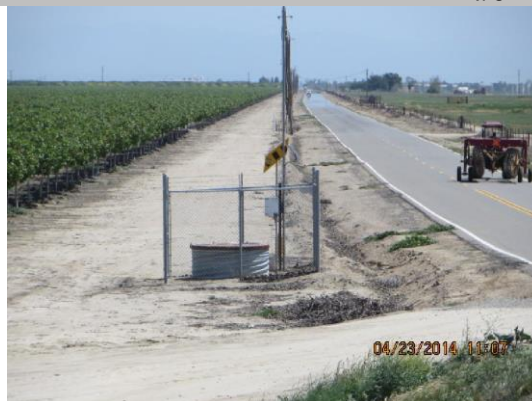
Photo 1 of 2 : UCIP\_SP\_2021\_39345\_71477.jpg

FS\_ID:39345  
 DS\_ID:24868  
 EP\_NO: N/A  
 Repair Type: Non-Urgent  
 Crossing Status: Indicator Found  
 UCIP Comments: 04/23/2014 Markers closer to the levee may be necessary to properly mark pipe crossing location. (DWR UCIP - W. Wylie)  
 FIELD\_STRUCT\_DESC: Steel natural gas pipeline of an unknown size through the levee, at an unknown depth. Corrugated metal pipe (CMP) riser and gas line marker off the landside (LS) toe.  
 FS Date: 4/22/2014

Gasline marker off LS toe.

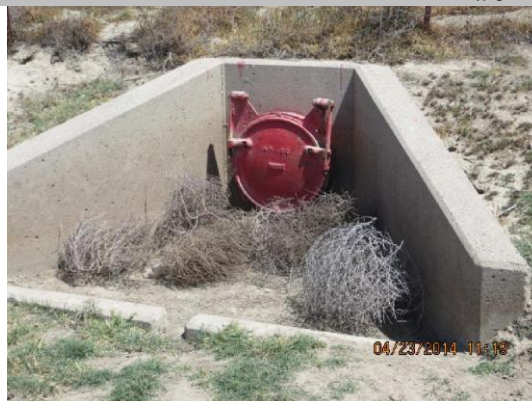
Photo 2 of 3 : UCIP\_SP\_2021\_62470\_62521.jpg

Headwall, pipe, and flapgate visible on WS toe.

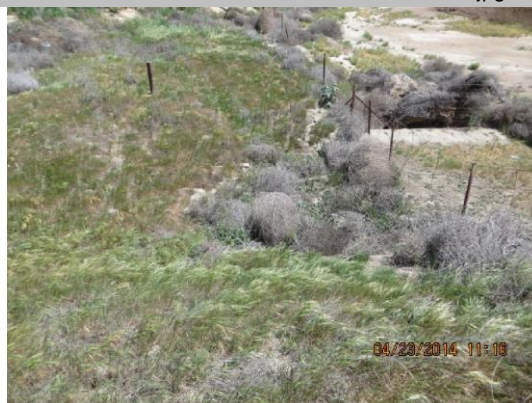
Photo 3 of 3 : UCIP\_SP\_2021\_62470\_62520.jpg

Headwall and pipe visible on LS toe.

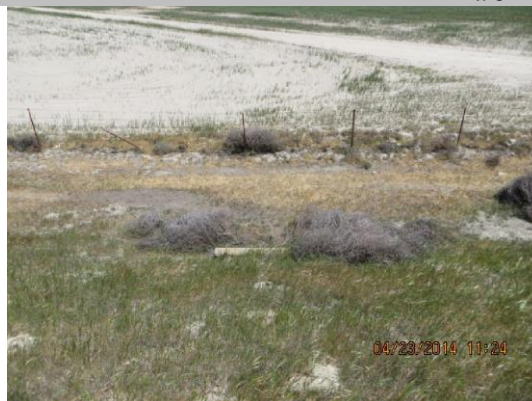
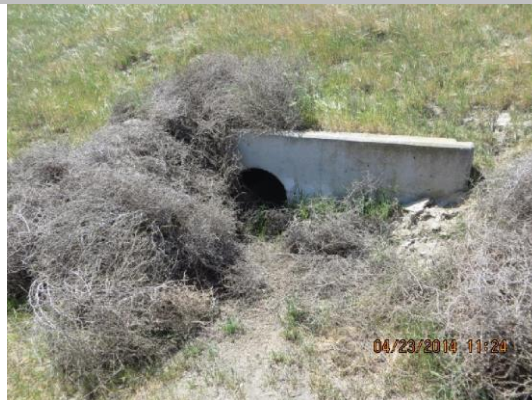
LM Start	19.86	Rating **	A/W	Issue No.	54
LM End	19.86	Issue Type +	Ma	Location *	
Category	Supplemental			GPS Latitude/Longitude	
				Start	End
Item	DWR UCIP LMA Responsibility			37.109284 °	37.109284 °
				-120.555948 °	-120.555948 °
DWR ID	19779				
Comment Code					
Inspector Comment					
FS_ID:62521 DS_ID:19779 EP_NO: N/A Repair Type: No Action Needed Crossing Status: Found UCIP Comments: FIELD_STRUCT_DESC: 24-inch corrugated metal gravity drainage pipe through the levee, 10.3 feet below the crown. Flap gate on the waterside (WS) end. Concrete headwall on the landside (LS) end. Concrete U-shaped headwall on the WS end. [Additional Reference(s): DWR Levee Log, 2002 (HLM 19.83), listed as a 24-inch corrugated metal pipe (CMP). USACE San Joaquin O&M Manual, Unit 601 Part 1 (SJR601.1), 1967, Revised 25 May 2011, (HLM 19.84), listed as a 24-inch CMP] FS Date: 4/23/2014

Headwall and pipe visible on LS toe.

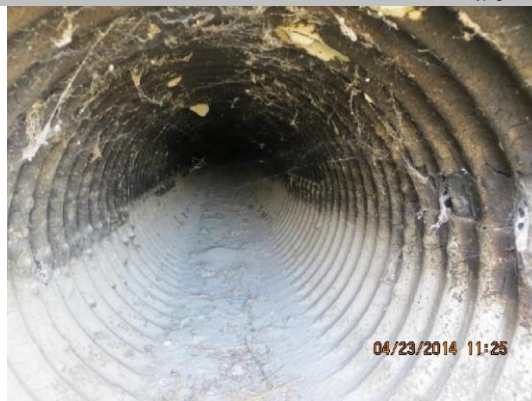
Inside pipe on LS toe.

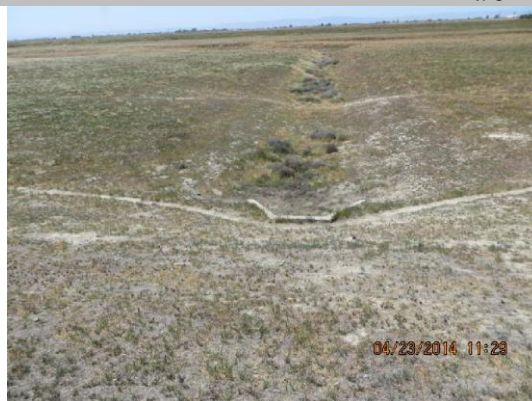
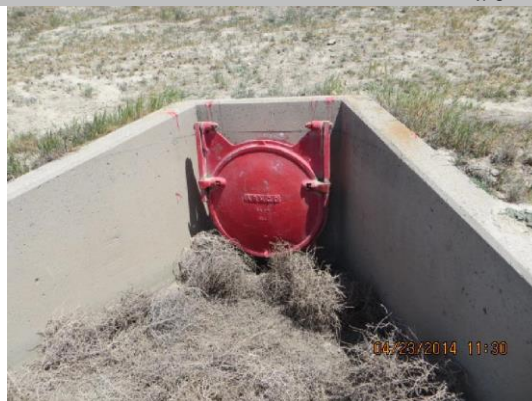
FS\_ID:62472  
DS\_ID:19780  
EP\_NO: N/A  
Repair Type: No Action Needed  
Crossing Status: Found  
UCIP Comments:  
FIELD\_STRUCT\_DESC: 36-inch corrugated metal gravity drainage pipe through the levee, 9.8 feet below the crown. Flap gate on the waterside (WS) end. Concrete headwall on the landside (LS) end. Concrete U-shaped headwall on the WS end. [Additional Reference(s): DWR Levee Log, 2002 (HLM 19.92), listed as a 36-inch corrugated metal pipe (CMP). USACE San Joaquin O&M Manual, Unit 601 Part 1 (SJR601.1), 1967, Revised 25 May 2011, (HLM 19.92), listed as a 36-inch CMP].  
FS Date: 4/23/2014

Headwall, pipe, and flapgate visible on WS toe.

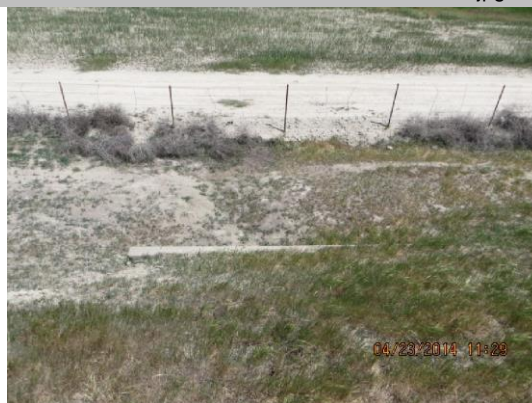
Headwall and pipe visible on LS toe.

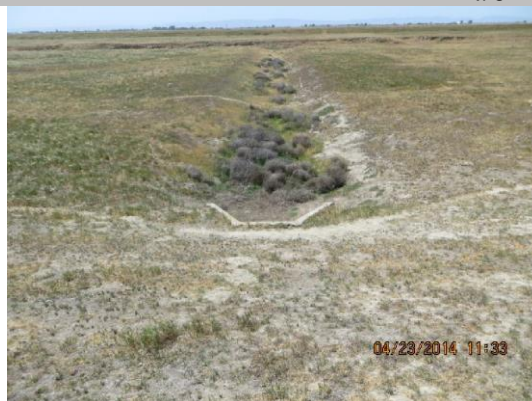
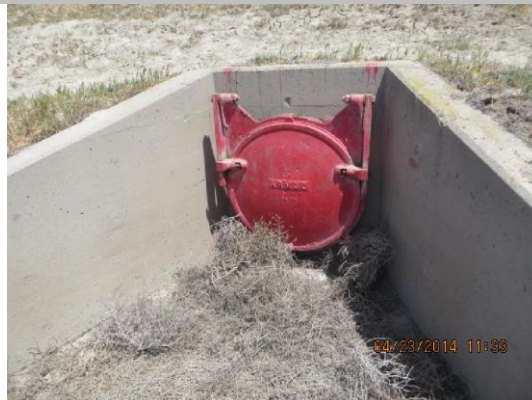
Comment Code						
Inspector Comment						
FS_ID:62522						
DS_ID:19781						
EP_NO: N/A						
Repair Type: No Action Needed						
Crossing Status: Found						
UCIP Comments:						
FIELD_STRUCT_DESC: 36-inch corrugated metal gravity drainage pipe through the levee, 9.9 feet below the crown. Flap gate on the waterside (WS) end. Concrete headwall on the landside (LS) end. Concrete U-shaped headwall on the WS end. [Additional Reference(s): DWR Levee Log, 2002 (HLM 20.04), listed as a 36-inch corrugated metal pipe (CMP). USACE San Joaquin O&M Manual, Unit 601 Part 1 (SJR601.1), 1967, Revised 25 May 2011, (HLM 20.05), listed as a 36-inch CMP]						
FS Date: 4/23/2014

Headwall, pipe, and flapgate visible on WS toe.

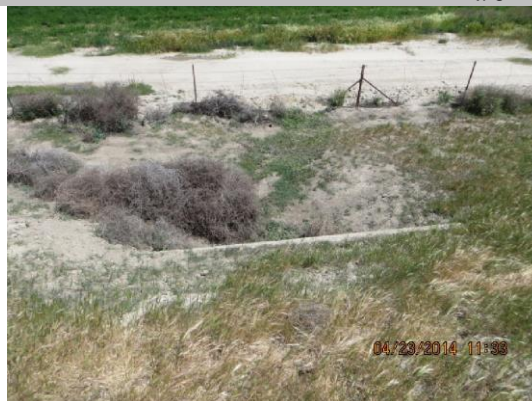
Headwall and pipe visible on LS toe.

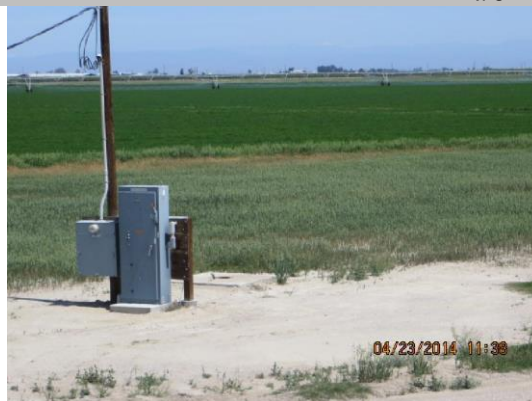
FS\_ID:34759  
 DS\_ID:19782  
 EP\_NO: 13828  
 Repair Type: Non-Urgent  
 Crossing Status: Not Found  
 UCIP Comments:  
 FIELD\_STRUCT\_DESC: \*DELETE\* NOT INSTALLED THROUGH THE LEVEE. 24-inch steel irrigation pipe through the levee, 4.0 feet below the crown. Pump missing from pad on the landward side. Steel cutoff wall around pipe at center of levee. Siphon breaker on apex of pipe on landward shoulder. Pre-existing ditch runs from waterward toe to channel. Pipe extends from pump to the channel. Rock revetment on the cut slopes of the inlet channel. (Permit No. 13828-1988)  
 FS Date: 4/23/2014

Well head visible off LS toe.

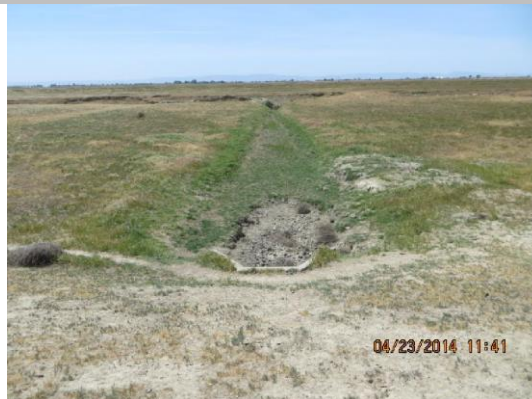
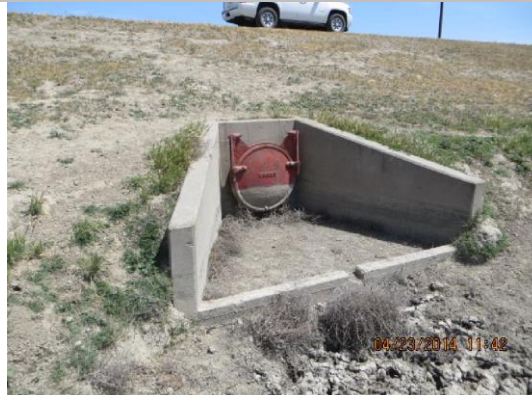
LM Start	20.24	Rating **	A/W	Issue No.	58	
LM End	20.24	Issue Type +	Ma	Location *		
Category	Supplemental			GPS Latitude/Longitude		
				Start		End
Item	DWR UCIP LMA Responsibility			37.105489 °		37.105489 °
				-120.551886 °		-120.551886 °
DWR ID	19783					
Comment Code						
Inspector Comment						
FS_ID:62474 DS_ID:19783 EP_NO: N/A Repair Type: No Action Needed Crossing Status: Found UCIP Comments: FIELD_STRUCT_DESC: 36-inch corrugated metal gravity drainage pipe through the levee, 10.6 feet below the crown. Flap gate on the waterside (WS) end. Concrete headwall on each end. [Additional Reference(s): DWR Levee Log, 2002 (HLM 20.18), listed as a 36-inch corrugated metal pipe (CMP). USACE San Joaquin O&M Manual, Unit 601 Part 1 (SJR601.1), 1967, Revised 25 May 2011, (HLM 20.18), listed as a 36-inch CMP] FS Date: 4/23/2014

Headwall, pipe, and flapgate visible on WS toe.

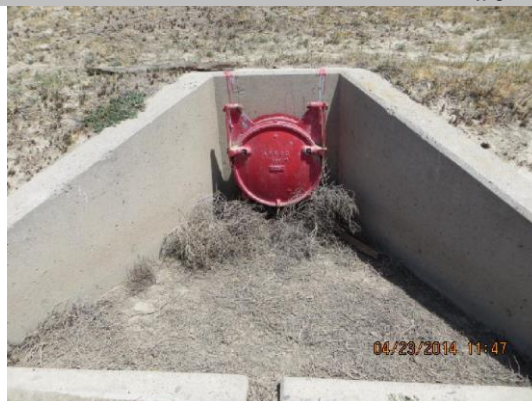
Headwall, pipe, and flapgate visible on WS toe.

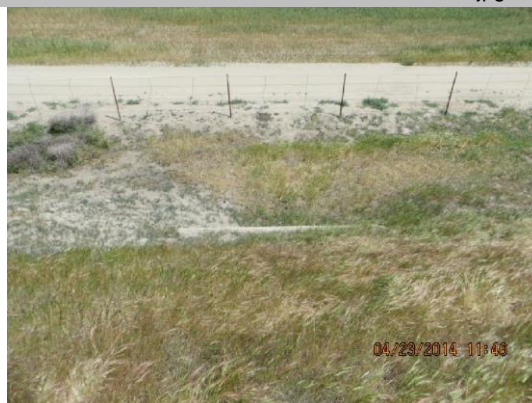
Headwall and pipe visible on LS toe.

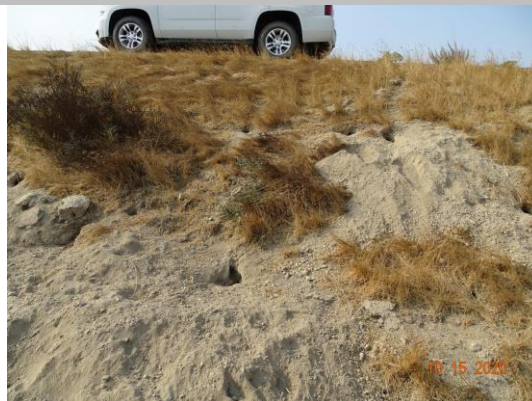
LM Start	20.93	Rating **	M	Issue No.	135
LM End	20.93	Issue Type +	Ma	Location *	LS
Category	Earthen Levee			GPS Latitude/Longitude	
				Start	End
Item	Animal Control			37.097826 °	37.097826 °
				-120.543984 °	-120.543984 °
DWR ID	DWR_NA0010_05_f_2020_135				
Comment Code					
A3 : No rodents visible, but rodent burrows visible; need to backfill and compact or grout burrows.					
Inspector Comment

View of rodent burrow in the landside slope. (Fall 2020)

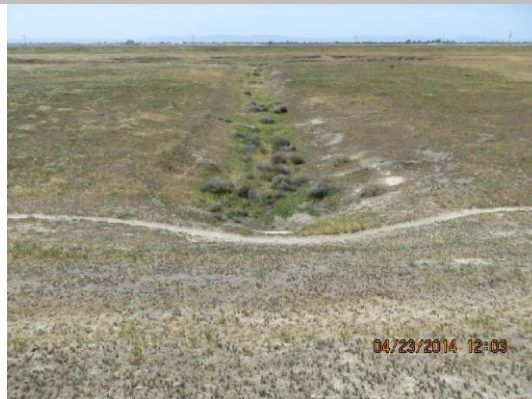
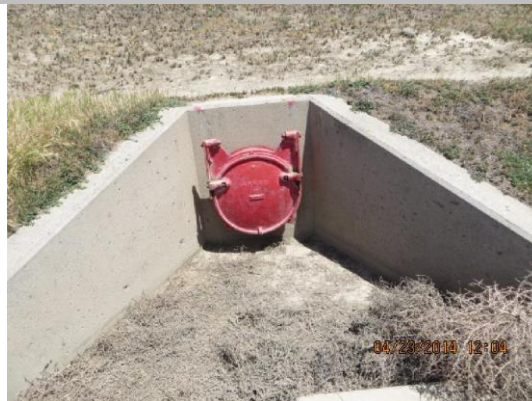
FS\_ID:62476  
DS\_ID:19785  
EP\_NO: N/A  
Repair Type: Non-Urgent  
Crossing Status: Found  
UCIP Comments: 04/23/2014 Dense vegetation limits the inspector's visibility to identify signs of pipe failure (leaks) along the landward slope. Recommend removing vegetation along pipe alignment to conduct proper inspection of structure. (W. Wylie - DWR UCIP)  
FIELD\_STRUCT\_DESC: 24-inch corrugated metal gravity drainage pipe through the levee, 11.8 feet below the crown. Flap gate on the waterside (WS) end. Concrete headwall on the landside (LS) end. Concrete U-shaped headwall on the WS end. [Additional Reference(s): DWR Levee Log, 2002 (HLM 21.07), listed as a 24-inch corrugated metal pipe (CMP). USACE San Joaquin O&M Manual, Unit 601 Part 1 (SJR601.1), 1967, Revised 25 May 2011, (HLM 21.08), listed as a 24-inch CMP]  
FS Date: 4/23/2014

Headwall, pipe, and flapgate visible on WS toe.

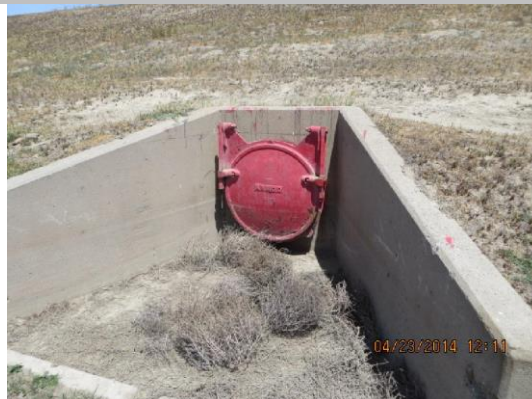
Headwall, pipe, and flapgate visible on WS toe.

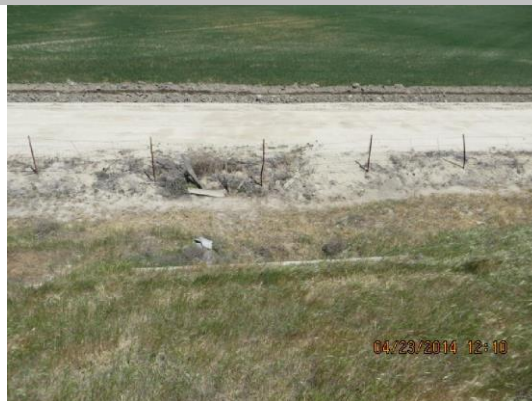
Headwall and pipe visible on LS toe.

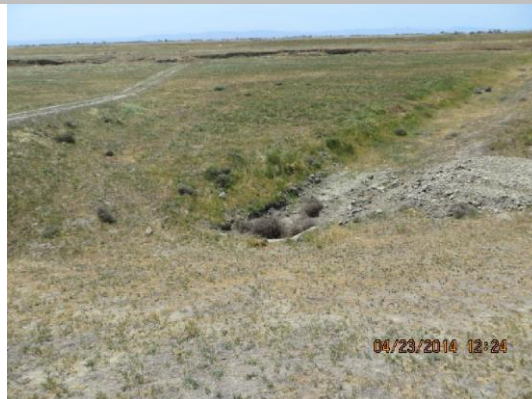
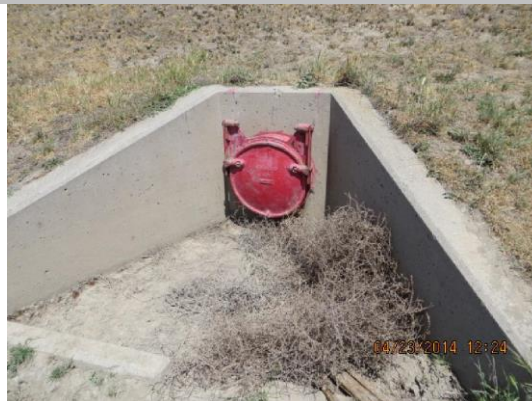
FS\_ID:62478  
DS\_ID:19787  
EP\_NO: N/A  
Repair Type: Non-Urgent  
Crossing Status: Found  
UCIP Comments: 04/23/2014 Dense vegetation limits the inspector's visibility to identify signs of pipe failure (leaks) along the landward slope. Recommend removing vegetation along pipe alignment to conduct proper inspection of structure. (W. Wylie - DWR UCIP)  
FIELD\_STRUCT\_DESC: 24-inch corrugated metal gravity drainage pipe through the levee, 12.4 feet below the crown. Flap gate on the waterside (WS) end. Concrete headwall on the landside (LS) end. Concrete U-shaped headwall on the WS end. [Additional Reference(s): DWR Levee Log, 2002 (HLM 21.81), listed as a 24-inch corrugated metal pipe (CMP). USACE San Joaquin O&M Manual, Unit 601 Part 1 (SJR601.1), 1967, Revised 25 May 2011, (HLM 21.81), listed as a 24-inch CMP]  
FS Date: 4/23/2014

Headwall, pipe, and flapgate visible on WS toe.

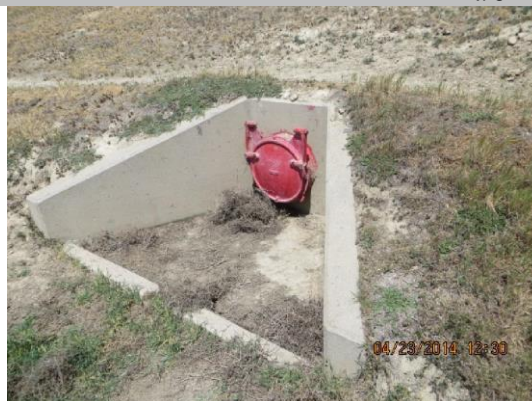
Headwall, pipe, and flapgate visible on WS toe.

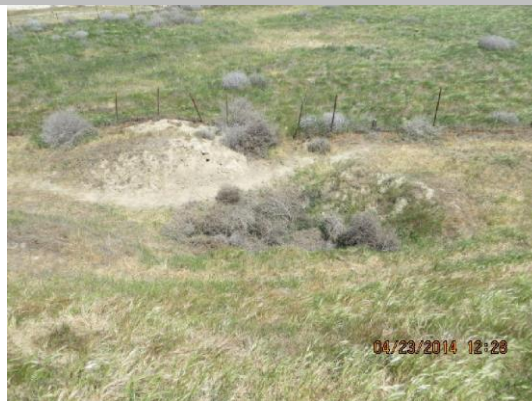
Headwall and pipe visible on LS toe.

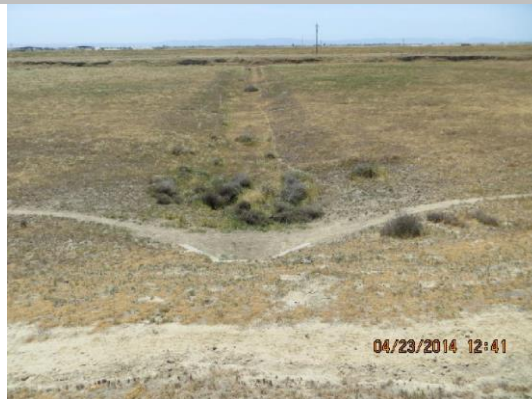
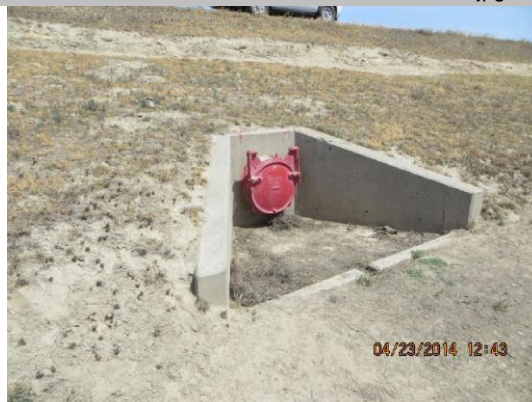
FS\_ID:62480  
DS\_ID:19789  
EP\_NO: N/A  
Repair Type: Non-Urgent  
Crossing Status: Found  
UCIP Comments: 04/23/2014 Dense vegetation limits the inspector's visibility to identify signs of pipe failure (leaks) along the landward slope. Recommend removing vegetation along pipe alignment to conduct proper inspection of structure. Sediment buildup in pipe visible from landward side--recommend contacting owner to clear pipe. (W. Wylie - DWR UCIP)  
FIELD\_STRUCT\_DESC: 24-inch corrugated metal gravity drainage pipe through the levee, 10.2 feet below the crown. Flap gate on the waterside (WS) end. Concrete headwall on the landside (LS) end. Concrete U-shaped headwall on the WS end. [Additional Reference(s): DWR Levee Log, 2002 (HLM 22.18), listed as a 24-inch corrugated metal pipe (CMP). USACE San Joaquin O&M Manual, Unit 601 Part 1 (SJR601.1), 1967, Revised 25 May 2011, (HLM 22.19), listed as a 24-inch CMP].

Headwall, pipe, and flapgate visible on WS toe.

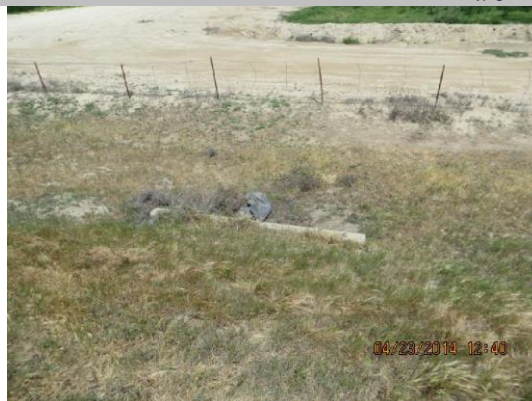
Headwall and pipe visible on LS toe.

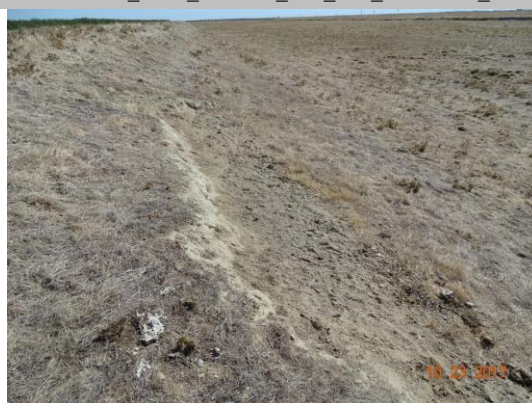
LM Start	22.35	Rating **	M	Issue No.	121
LM End	22.35	Issue Type +	Ma	Location *	WS
Category	Earthen Levee			GPS Latitude/Longitude	
				Start	End
Item	Animal Control			37.082696 °	37.082696 °
				-120.527620 °	-120.527620 °
DWR ID	DWR_NA0010_05_f_2017_121				
Comment Code					
A2 : Repair the levee slope damaged by livestock and prevent large animal access.					
Inspector Comment					
Waterside slope damaged by animal traffic.

Looking southeast at the waterside slope.

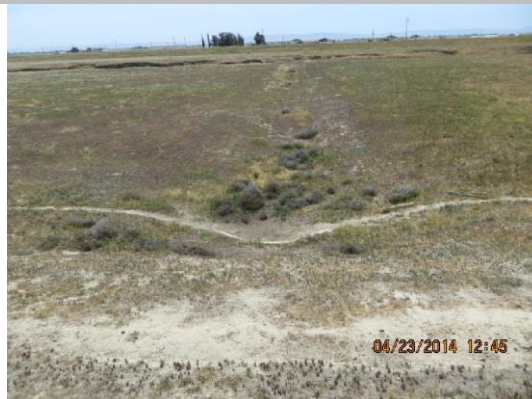
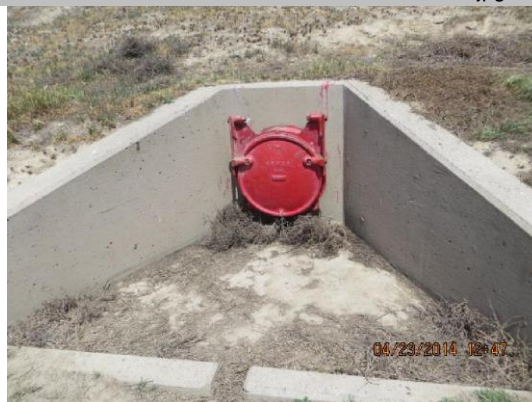
Photo 1 of 3 : UCIP\_SP\_2021\_62481\_62596.jpg

FS\_ID:62481  
DS\_ID:19790  
EP\_NO: N/A  
Repair Type: Non-Urgent  
Crossing Status: Found  
UCIP Comments: 04/23/2014 Dense vegetation limits the inspector's visibility to identify signs of pipe failure (leaks) along the landward slope. Recommend removing vegetation along pipe alignment to conduct proper inspection of structure. Sediment buildup in pipe visible from landward side--recommend contacting owner to clear pipe. (W. Wylie - DWR UCIP)  
FIELD\_STRUCT\_DESC: 24-inch corrugated metal gravity drainage pipe through the levee, 10.4 feet below the crown. Flap gate on the waterside (WS) end. Concrete headwall on the landside (LS) end. Concrete U-shaped headwall on the WS end. [Additional Reference(s): DWR Levee Log, 2002 (HLM 22.46), listed as a 24-inch corrugated metal pipe (CMP). USACE San Joaquin O&M Manual, Unit 601 Part 1 (SJR601.1), 1967, Revised 25 May 2011, (HLM 22.46), listed as a 24-inch CMP]

Headwall, pipe, and flapgate visible on WS toe.

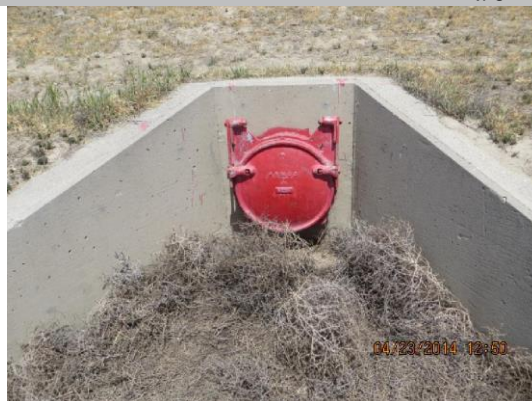
Photo 2 of 3 : UCIP\_SP\_2021\_62482\_62600.jpg

LM Start	22.89	Rating **	M	Issue No.	66 (cont)
LM End	22.89	Issue Type +	Ma	Location *	
Category	Supplemental			GPS Latitude/Longitude	
				Start	End
Item	DWR UCIP LMA Responsibility			37.076830 °	37.076830 °
				-120.521116 °	-120.521116 °
DWR ID	19791

Headwall, pipe, and flapgate visible on WS toe.

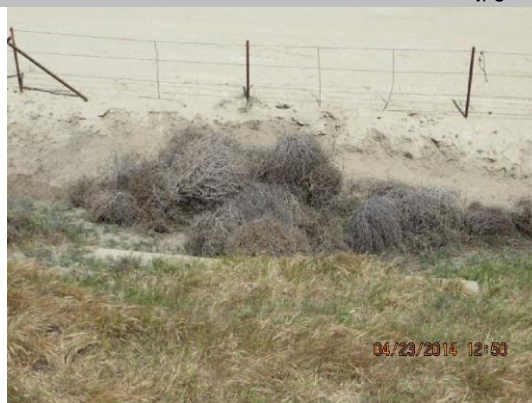
Photo 3 of 3 : UCIP\_SP\_2021\_62482\_62602.jpg

Headwall and pipe visible on LS toe.

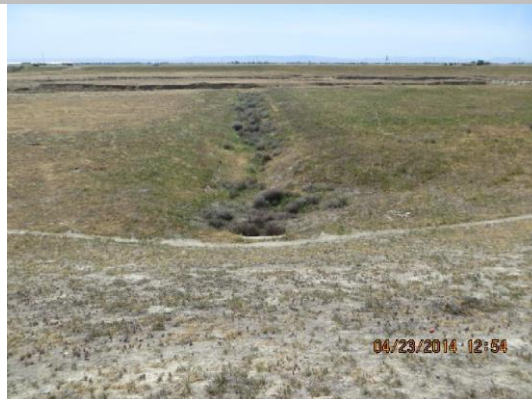
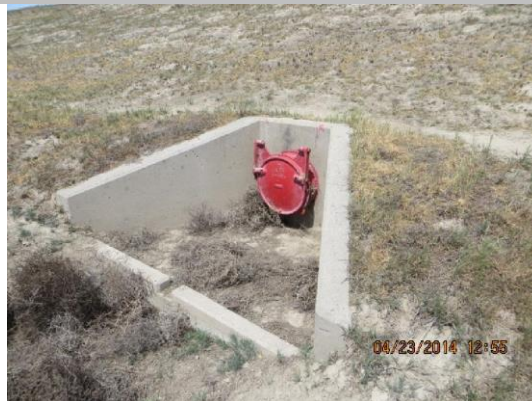
Photo 1 of 3 : UCIP\_SP\_2021\_62483\_62606.jpg

FS\_ID:62483  
DS\_ID:19792  
EP\_NO: N/A  
Repair Type: Non-Urgent  
Crossing Status: Found  
UCIP Comments: 04/23/2014 Dense vegetation limits the inspector's visibility to identify signs of pipe failure (leaks) along the landward slope. Recommend removing vegetation along pipe alignment to conduct proper inspection of structure. (W. Wylie - DWR UCIP)  
FIELD\_STRUCT\_DESC: 24-inch corrugated metal gravity drainage pipe through the levee, 11.1 feet below the crown. Flap gate on the waterside (WS) end. Concrete headwall on the landside (LS) end. Concrete U-shaped headwall on the WS end. [Additional Reference(s): DWR Levee Log, 2002 (HLM 22.93), listed as a 24-inch corrugated metal pipe (CMP). USACE San Joaquin O&M Manual, Unit 601 Part 1 (SJR601.1), 1967, Revised 25 May 2011, (HLM 22.94), listed as a 24-inch CMP]  
FS Date: 4/23/2014

Headwall, pipe, and flapgate visible on WS toe.

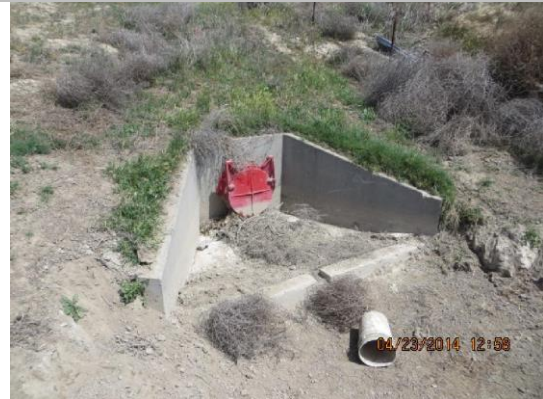
Photo 2 of 3 : UCIP\_SP\_2021\_62484\_62610.jpg

LM Start	<b>23.17</b>	Rating **	M	Issue No.	<b>68 (cont)</b>
LM End	<b>23.17</b>	Issue Type +	En	Location *	
Category	Supplemental		GPS Latitude/Longitude		
			Start	End	
Item	DWR UCIP Field Study		37.073901 °	37.073901 °	
			-120.517651 °	-120.517651 °	
DWR ID	19793

Headwall, pipe, and flapgate visible on WS toe.

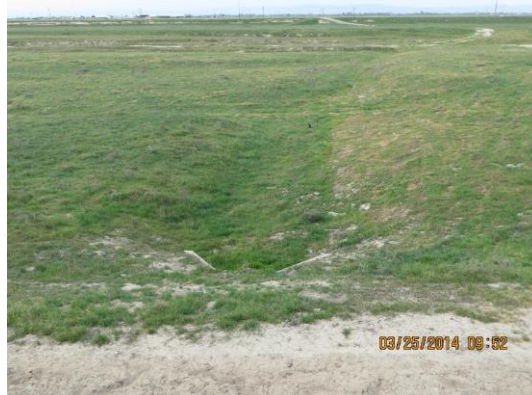
Photo 1 of 3 : UCIP\_SP\_2021\_62485\_59262.jpg

Comment Code						
Inspector Comment						
FS_ID:62485 DS_ID:19794 EP_NO: N/A Repair Type: No Action Needed Crossing Status: Found UCIP Comments: FIELD_STRUCT_DESC: 30-inch corrugated metal gravity drainage pipe through the levee, 11.6 feet below the crown. Flap gate on the waterside (WS) end. Concrete headwall on the landside (LS) end. Concrete U-shaped headwall on the WS end. [Additional Reference(s): DWR Levee Log, 2002 (HLM 23.14), listed as a 30-inch corrugated metal pipe (CMP). USACE San Joaquin O&M Manual, Unit 601 Part 1 (SJR601.1), 1967, Revised 25 May 2011, (HLM 23.15), listed as a 30-inch CMP] FS Date: 3/25/2014 9:04:00 AM

Concrete headwall on WS toe.

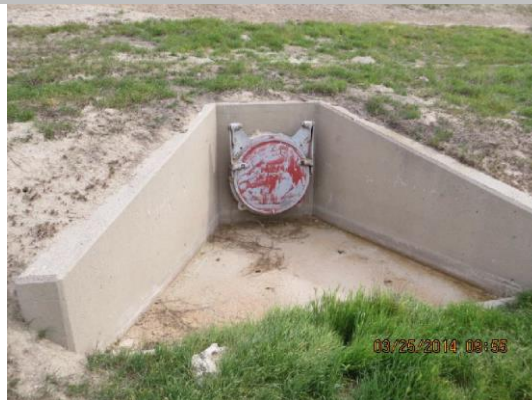
Photo 2 of 3 : UCIP\_SP\_2021\_62485\_59263.jpg

Flapgate and concrete headwall on WS toe.

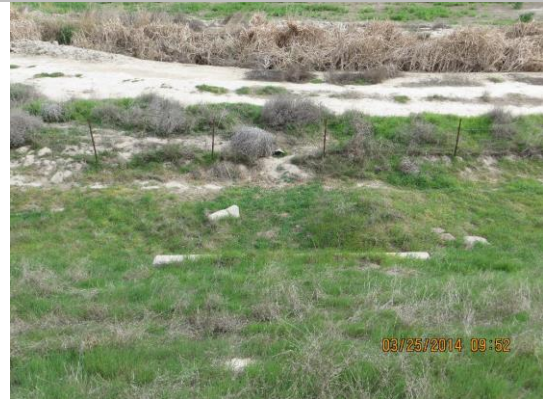
Photo 3 of 3 : UCIP\_SP\_2021\_62485\_59261.jpg

Concrete headwall on LS toe.

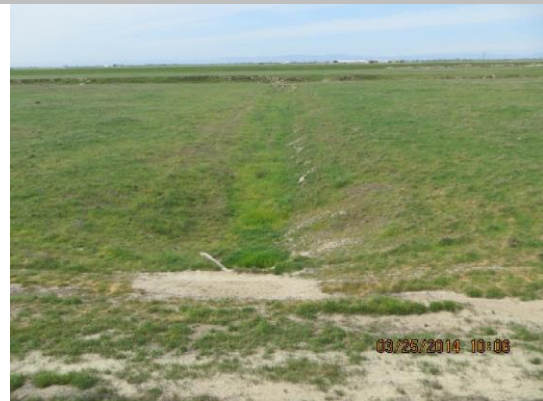
Photo 1 of 3 : UCIP\_SP\_2021\_62488\_59272.jpg

FS\_ID:62488  
 DS\_ID:19796  
 EP\_NO: N/A  
 Repair Type: Non-Urgent  
 Crossing Status: Found  
 UCIP Comments: 03/25/2014 Sediment buildup in pipe visible from landward side--recommend contacting owner to clear pipe. (W. Wylie - DWR UCIP)  
 FIELD\_STRUCT\_DESC: 30-inch corrugated metal gravity drainage pipe through the levee, 12.1 feet below the crown. Flap gate on the waterside (WS) end. Concrete U-shaped headwall on the WS end.  
 [Additional Reference(s): DWR Levee Log, 2002 (HLM 23.61), listed as a 30-inch corrugated metal pipe (CMP). USACE San Joaquin O&M Manual, Unit 601 Part 1 (SJR601.1), 1967, Revised 25 May 2011, (HLM 23.62), listed as a 30-inch CMP]  
 FS Date: 3/25/2014

Concrete headwall on WS toe.

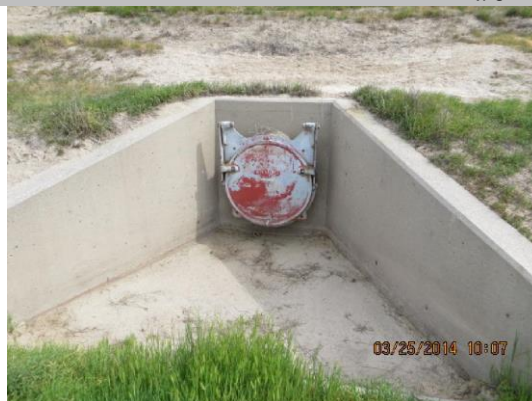
Photo 2 of 3 : UCIP\_SP\_2021\_62488\_59270.jpg

Flapgate on Concrete headwall on WS toe.

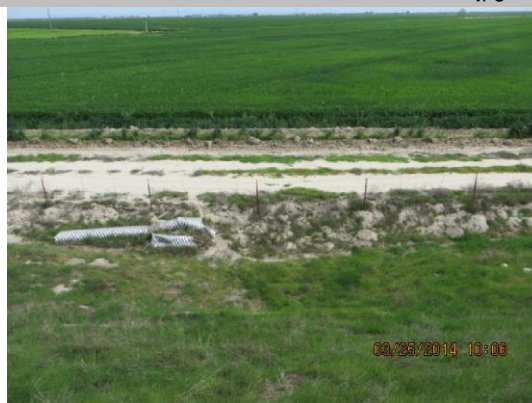
Photo 3 of 3 : UCIP\_SP\_2021\_62488\_59271.jpg

Concrete headwall on LS toe.

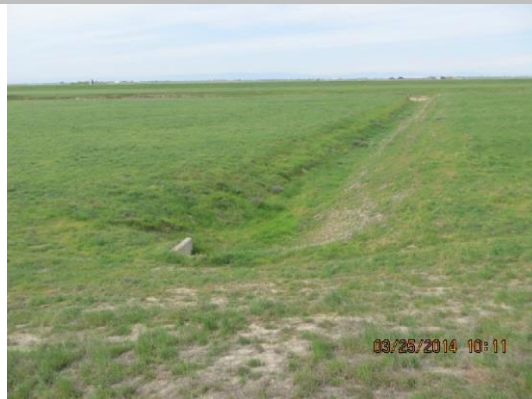
Photo 1 of 3 : UCIP\_SP\_2021\_62489\_59282.jpg

Comment Code					
Inspector Comment					
FS_ID:62489 DS_ID:19797 EP_NO: N/A Repair Type: Non-Urgent Crossing Status: Found UCIP Comments: 03/25/2014 Minor sediment/debris buildup in pipe visible from landward side--recommend contacting owner to clear pipe. (W. Wylie - DWR UCIP) FIELD_STRUCT_DESC: 36-inch corrugated metal gravity drainage pipe through the levee, 12.1 feet below the crown. Flap gate on the waterside (WS) end. Concrete headwall on the landside (LS) end. Concrete U-shaped headwall on the WS end. [Additional Reference(s): DWR Levee Log, 2002 (HLM 23.92), listed as a 36-inch corrugated metal pipe (CMP). USACE San Joaquin O&M Manual, Unit 601 Part 1 (SJR601.1), 1967, Revised 25 May 2011, (HLM 23.85), listed as a 36-inch CMP] FS Date: 3/25/2014

Concrete headwall on WS toe.

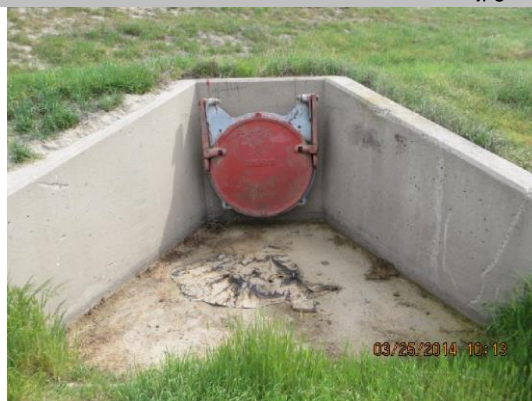
Photo 2 of 3 : UCIP\_SP\_2021\_62489\_59280.jpg

Flapgate at Concrete headwall on WS toe.

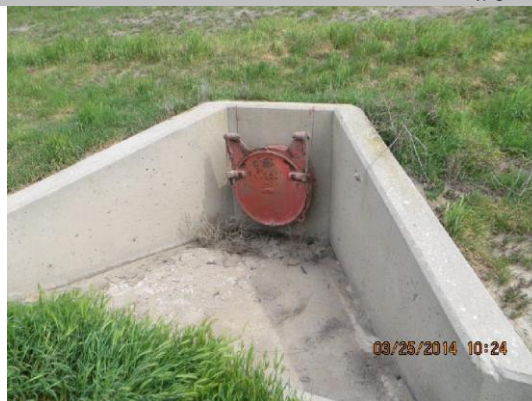
Photo 2 of 3 : UCIP\_SP\_2021\_62490\_59285.jpg

LM Start	<b>24.28</b>	Rating **	M	Issue No.	<b>72 (cont)</b>
LM End	<b>24.28</b>	Issue Type +	Ma	Location *	
Category	Supplemental		GPS Latitude/Longitude		
			Start	End	
Item	DWR UCIP LMA Responsibility		37.061724 °	37.061724 °	
			-120.504512 °	-120.504512 °	
DWR ID	19798

Flapgate at concrete headwall at WS toe.

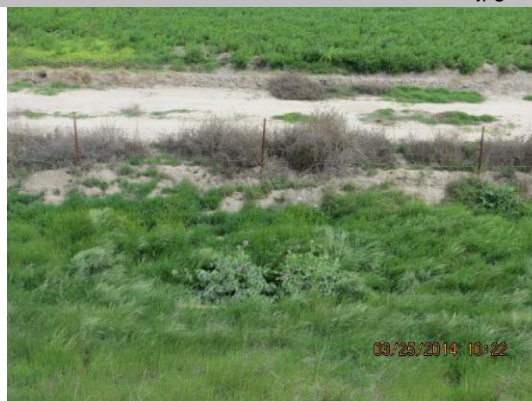
Photo 3 of 3 : UCIP\_SP\_2021\_62490\_59286.jpg

Concrete headwall at LS toe.

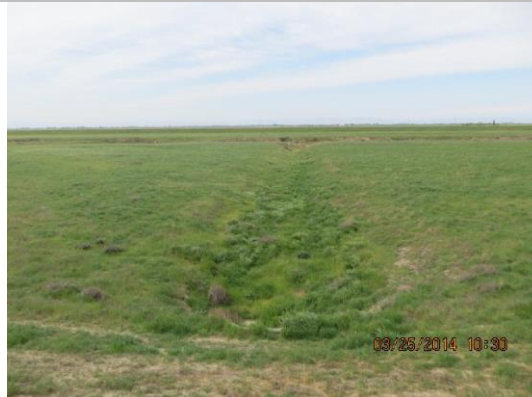
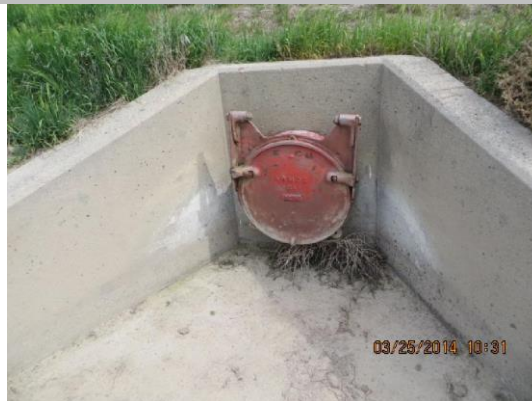
Photo 1 of 3 : UCIP\_SP\_2021\_62491\_59292.jpg

FS\_ID:62491  
DS\_ID:19799  
EP\_NO: N/A  
Repair Type: Non-Urgent  
Crossing Status: Found  
UCIP Comments: 03/25/2014 Dense vegetation limits the inspector's visibility to identify signs of pipe failure (leaks) along the landward slope. Recommend removing vegetation along pipe alignment to conduct proper inspection of structure. (W. Wylie - DWR UCIP)  
FIELD\_STRUCT\_DESC: 24-inch corrugated metal gravity drainage pipe through the levee, 11.2 feet below the crown. Flap gate on the waterside (WS) end. Concrete headwall on the landside (LS) end. Concrete U-shaped headwall on the WS end. [Additional Reference(s): DWR Levee Log, 2002 (HLM 24.46), listed as a 24-inch corrugated metal pipe (CMP). USACE San Joaquin O&M Manual, Unit 601 Part 1 (SJR601.1), 1967, Revised 25 May 2011, (HLM 24.46), listed as a 24-inch CMP]  
FS Date: 3/25/2014

Concrete headwall on WS toe.

Flapgate at Concrete headwall on WS toe.

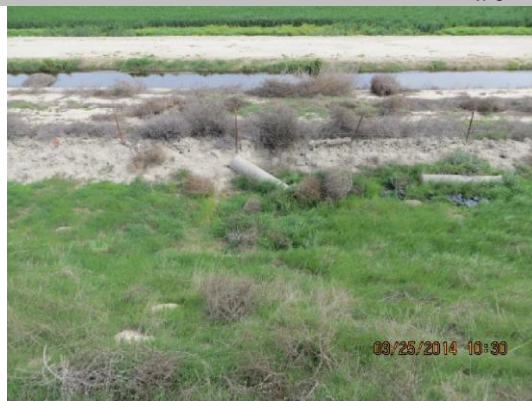
Photo 3 of 3 : UCIP\_SP\_2021\_62491\_59291.jpg

Concrete headwall on LS toe.

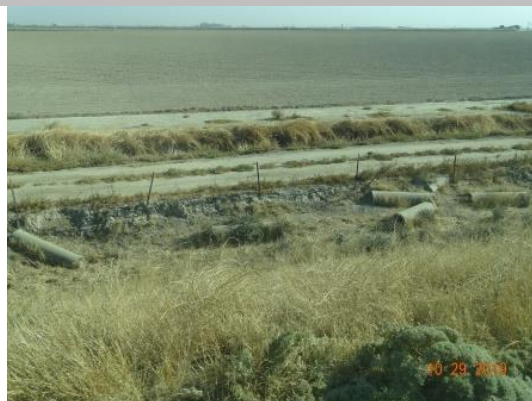
Photo 1 of 1 : SP\_2021\_NA0010\_123\_175\_20210308\_00048.jpg

LM Start	24.56	Rating **	M	Issue No.	175
LM End	24.56	Issue Type +	En	Location *	LS
Category	Earthen Levee			GPS Latitude/Longitude	
				Start	End
Item	Encroachments			37.058672 °	37.058672 °
				-120.501218 °	-120.501218 °
DWR ID	DWR_NA0010_05_f _ 2019_175				
Comment Code					
PI : Pipe					
Inspector Comment					
Concrete pipe left on landside toe.

Sections of concrete pipe left along the landside toe. (Fall 2019)

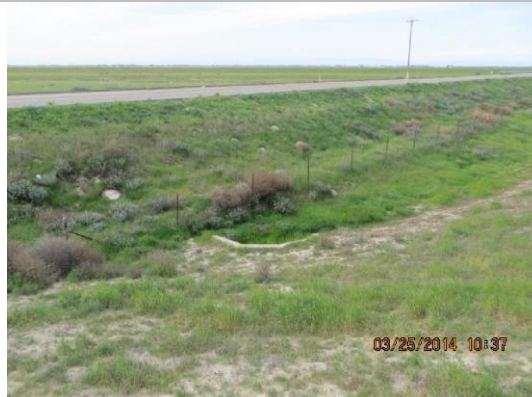
Photo 1 of 3 : UCIP\_SP\_2021\_62492\_59297.jpg

Comment Code						
Inspector Comment						
FS_ID:62492						
DS_ID:19800						
EP_NO: N/A						
Repair Type: No Action Needed						
Crossing Status: Found						
UCIP Comments:						
FIELD_STRUCT_DESC: 24-inch corrugated metal gravity drainage pipe through the levee, 10.7 feet below the crown. Flap gate on the waterside (WS) end. Concrete headwall on the landside (LS) end. Concrete U-shaped headwall on the WS end. [Additional Reference(s): DWR Levee Log, 2002 (HLM 24.82), listed as a 24-inch corrugated metal pipe (CMP). USACE San Joaquin O&M Manual, Unit 601 Part 1 (SJR601.1), 1967, Revised 25 May 2011, (HLM 24.82), listed as a 24-inch CMP]						
FS Date: 3/25/2014

Concrete headwall on WS toe.
