# Flood Control Project Maintenance Levee Inspections LMA District Cover Sheet

## Lower San Joaquin Levee District

**Flood Control Project Maintenance  
Levee Inspections  
Unit Cover Sheet**

Waterway			Bank	Unit Miles
Unit No. 01 San Joaquin River			Right	22.52
	Spring (March - May)	Summer (June - August)	(September - November) Fall	Winter (December - February)
Unit Maintenance Rating (Fall Only)				
Date of Inspection	5/4/2021 - 5/4/2021			
DWR Inspector	Corey Fujitani			
Accompanied By

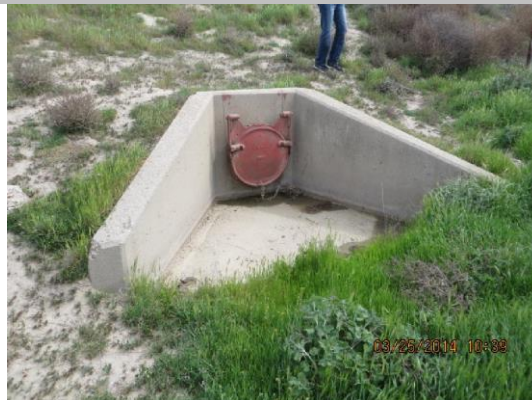
Photo 2 of 3 : UCIP\_SP\_2021\_62492\_59295.jpg

Flapgate on concrete headwall on WS toe.

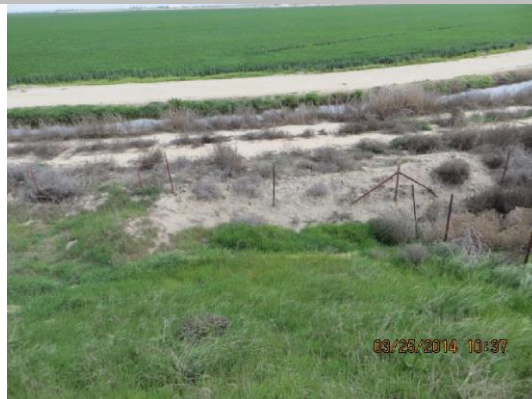
Photo 3 of 3 : UCIP\_SP\_2021\_62492\_59296.jpg

Concrete headwall on LS toe.

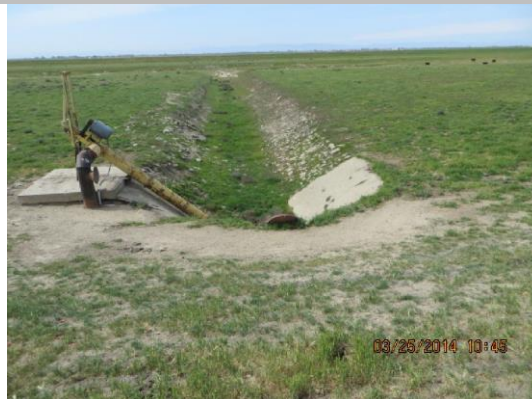
Photo 1 of 3 : UCIP\_SP\_2021\_62493\_59302.jpg

FS\_ID:62493  
 DS\_ID:19801  
 EP\_NO: N/A  
 Repair Type: No Action Needed  
 Crossing Status: Found  
 UCIP Comments:  
 FIELD\_STRUCT\_DESC: 30-inch corrugated metal gravity drainage pipe through the levee, 10.9 feet below the crown. Flap gate on the waterside (WS) end. Concrete headwall on the landside (LS) end. Concrete U-shaped headwall on the WS end. [Additional Reference(s): DWR Levee Log, 2002 (HLM 24.86), listed as a 30-inch corrugated metal pipe (CMP). USACE San Joaquin O&M Manual, Unit 601 Part 1 (SJR601.1), 1967, Revised 25 May 2011, (HLM 24.87), listed as a 30-inch CMP]  
 FS Date: 3/25/2014

Flapgate and channel off WS toe.

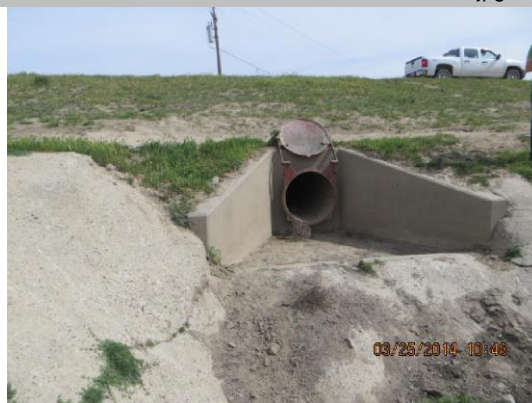
Photo 3 of 3 : UCIP\_SP\_2021\_62493\_59303.jpg

Flapgate on headwall at WS toe.

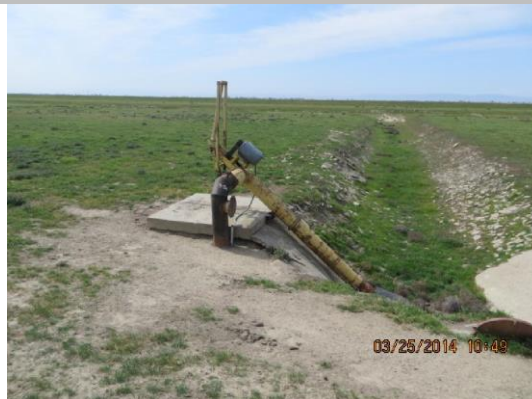
Photo 1 of 3 : UCIP\_SP\_2021\_62494\_59306.jpg

FS\_ID:62494  
DS\_ID:19802  
EP\_NO: 12873  
Repair Type: Non-Urgent  
Crossing Status: Found  
UCIP Comments: 03/25/2014 Clear soil from siphon breaker and install a protective riser. (W. Wylie - DWR UCIP)  
FIELD\_STRUCT\_DESC: 16-inch coated steel irrigation discharge pipe through the levee, 2 feet below the crown. Slant pump at the channel on the waterside (WS) toe. Siphon breaker on the WS shoulder. Gate valve on the landside (LS) toe. A preexisting ditch runs from the WS toe to the channel. Riprap placed around the intake. 2-inch polyvinyl chloride (PVC) electrical conduit at the same location. (Plans to install a pump with a discharge pipe through the levee authorized under Permit No. 12873, 1980 - Bowles Farming Company). [Additional Reference(s): DWR Levee Log, 2002 (HLM 24.88), listed as a 16-inch pipe]  
FS Date: 3/25/2014

Slant pump at channel on WS toe.

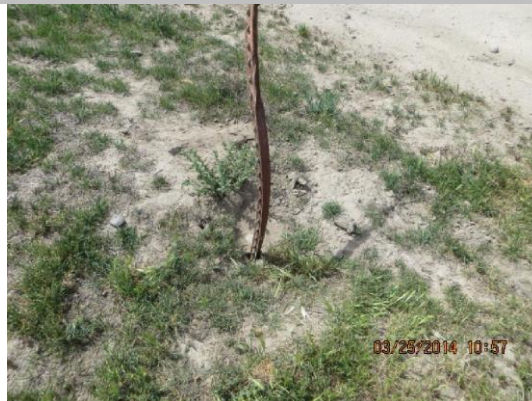
Photo 2 of 3 : UCIP\_SP\_2021\_62494\_59307.jpg

Buried Siphon breaker on WS shoulder.

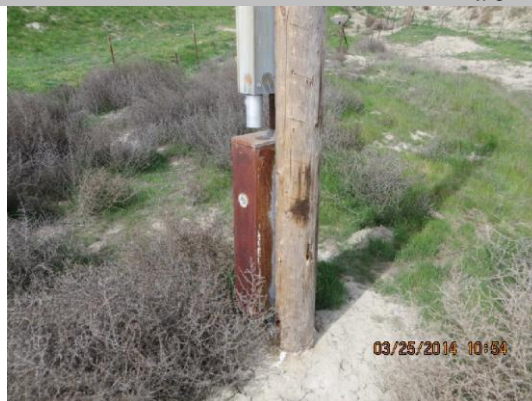
Photo 3 of 3 : UCIP\_SP\_2021\_62494\_59304.jpg

Power pole, meter, and electrical panel off LS toe.

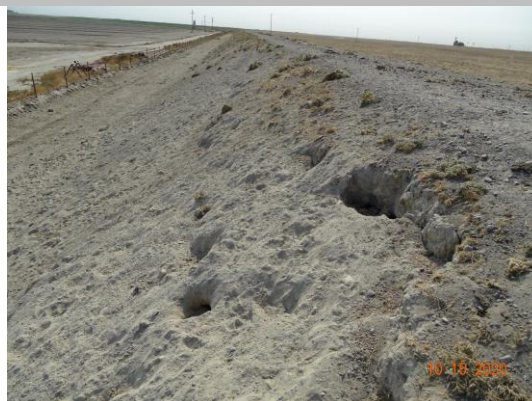
Photo 1 of 1 : SP\_2021\_NA0010\_123\_123\_20210308\_00019.jpg

LM Start	25.09	Rating **	A/W	Issue No.	123
LM End	25.26	Issue Type +	Ma	Location *	LS
Category	Earthen Levee			GPS Latitude/Longitude	
				Start	End
Item	Animal Control			37.053103 °	37.051252 °
				-120.494651 °	-120.492368 °
DWR ID	DWR_NA0010_05_f_2017_123				
Comment Code					
A1 : Exterminate rodents and backfill and compact or grout burrows.					
Inspector Comment

View of the landside slope looking upstream. (Fall 2020)

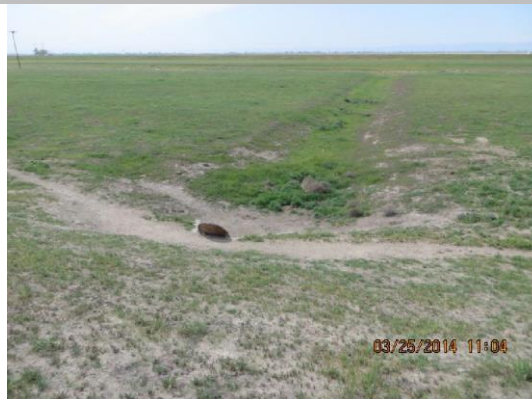
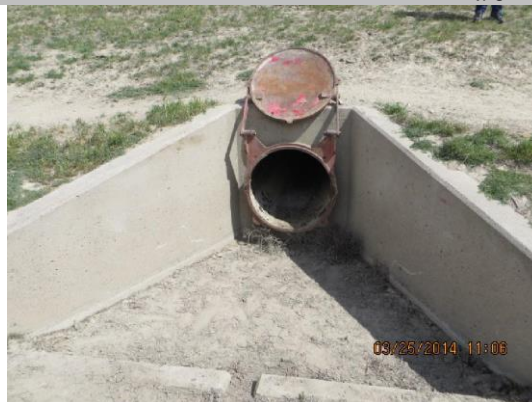
Comment Code					
Inspector Comment					
FS_ID:62518 DS_ID:19803 EP_NO: N/A Repair Type: Non-Urgent Crossing Status: Found UCIP Comments: 03/25/2014 Flapgate propped open during flood season. (W. Wylie - DWR UCIP) FIELD_STRUCT_DESC: 30-inch corrugated metal gravity drainage pipe through the levee, 11.3 feet below the crown. Flap gate on the waterside (WS) end. Concrete headwall on the landside (LS) end. Concrete U-shaped headwall on the WS end. [Additional Reference(s): DWR Levee Log, 2002 (HLM 25.14), listed as a 30-inch corrugated metal pipe (CMP). USACE San Joaquin O&M Manual, Unit 601 Part 1 (SJR601.1), 1967, Revised 25 May 2011, (recorded incorrectly as HLM 25.43 correct HLM 25.13), listed as a 30-inch CMP] FS Date: 10/27/2020 2:27:00 PM

Concrete headwall and flapgate on WS toe.

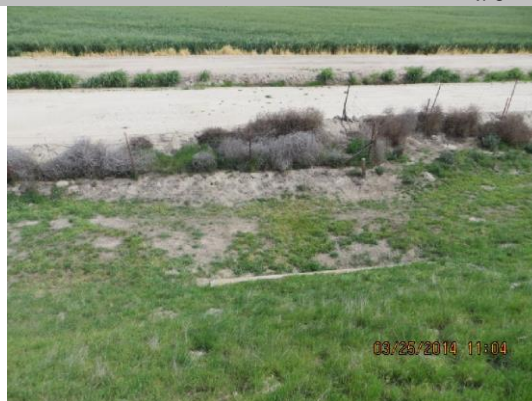
Photo 3 of 3 : UCIP\_SP\_2021\_62518\_59310.jpg

Concrete headwall on LS toe.

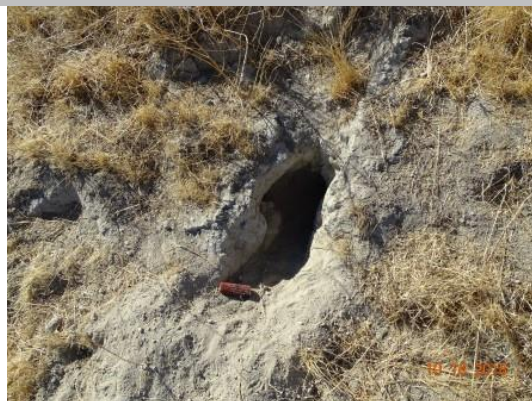
Photo 1 of 1 : SP\_2021\_NA0010\_123\_9\_20210308\_00007.jpg

LM Start	25.28	Rating **	M	Issue No.	9
LM End	25.35	Issue Type +	Ma	Location *	LS
Category	Earthen Levee			GPS Latitude/Longitude	
				Start	End
Item	Animal Control			37.051076 °	37.050349 °
				-120.492153 °	-120.491269 °
DWR ID	DWR_NA0010_05_s_2012_9				
Comment Code					
A1 : Exterminate rodents and backfill and compact or grout burrows.					
Inspector Comment					
Several rodent holes are noted along this section.

View of representative rodent burrow. (Fall 2018)

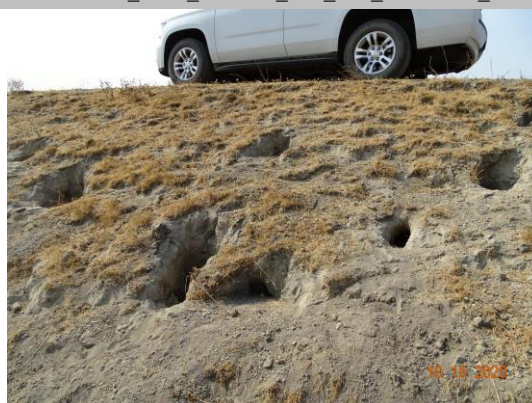
Photo 1 of 1 : SP\_2021\_NA0010\_123\_148\_20210308\_00037.jpg

LM Start	25.58	Rating **	U	Issue No.	148
LM End	25.60	Issue Type +	Ma	Location *	LS
Category	Earthen Levee			GPS Latitude/Longitude	
				Start	End
Item	Animal Control			37.047827 °	37.047551 °
				-120.488738 °	-120.488527 °
DWR ID	DWR_NA0010_05_f_2020_148				
Comment Code					
A3 : No rodents visible, but rodent burrows visible; need to backfill and compact or grout burrows.					
Inspector Comment

View of burrows in the landside. (Fall 2020)

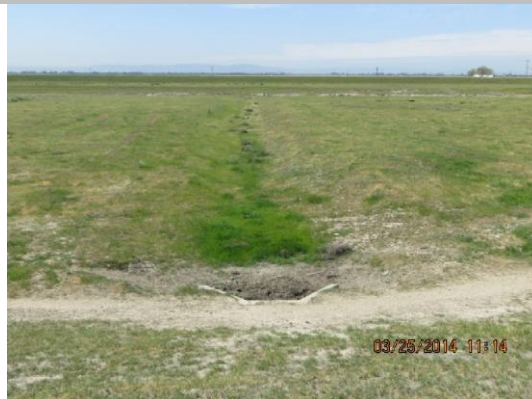
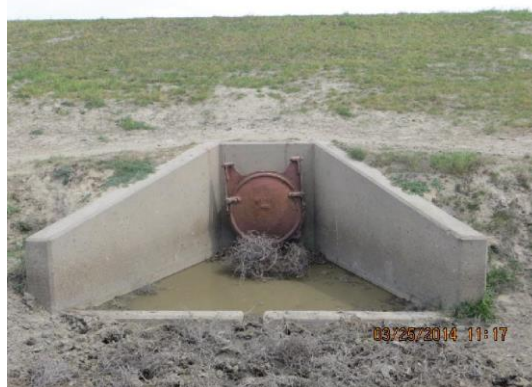
Comment Code						
Inspector Comment						
FS_ID:62496 DS_ID:19804 EP_NO: N/A Repair Type: Non-Urgent Crossing Status: Found UCIP Comments: 03/25/2014 Dense vegetation limits the inspector's visibility to identify signs of pipe failure (leaks) along the landward slope. Recommend removing vegetation along pipe alignment to conduct proper inspection of structure. Sediment buildup in pipe visible from landward side--recommend contacting owner to clear pipe. (W. Wylie - DWR UCIP) FIELD_STRUCT_DESC: 30-inch corrugated metal gravity drainage pipe through the levee, 12 feet below the crown. Flap gate on the waterside (WS) end. Concrete headwall on the landside (LS) end. Concrete U-shaped headwall on the WS end. [Additional Reference(s): DWR Levee Log, 2002 (HLM 25.51), listed as a 30-inch corrugated metal pipe (CMP). USACE San Joaquin O&M Manual, Unit 601 Part 1 (SJR601.1), 1967, Revised 25 May 2011, (HLM 25.51), listed as a 30-inch CMP] FS Date: 3/25/2014

Concrete headwall on WS toe.

Flapgate on concrete headwall at WS toe.

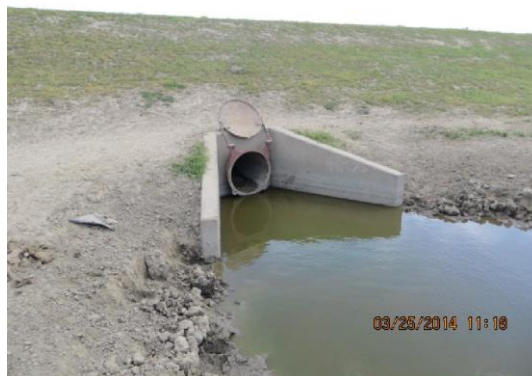
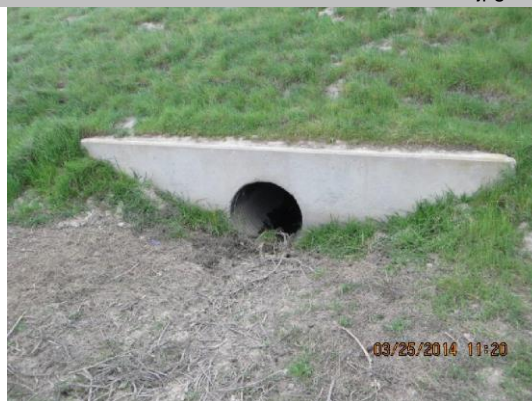
FS\_ID:62497  
DS\_ID:19805  
EP\_NO: N/A  
Repair Type: Non-Urgent  
Crossing Status: Found  
UCIP Comments: 03/25/2014 Sediment buildup in pipe visible from landward side--recommend contacting owner to clear pipe. (W. Wylie - DWR UCIP)  
FIELD\_STRUCT\_DESC: 30-inch corrugated metal gravity drainage pipe through the levee, 12.1 feet below the crown. Flap gate on the waterside (WS) end. Concrete headwall on the landside (LS) end. Concrete U-shaped headwall on the WS end. [Additional Reference(s): DWR Levee Log, 2002 (HLM 25.53), listed as a 30-inch corrugated metal pipe (CMP). USACE San Joaquin O&M Manual, Unit 601 Part 1 (SJR601.1), 1967, Revised 25 May 2011, (HLM 25.53), listed as a 30-inch CMP]  
FS Date: 3/25/2014

Flapgate on headwall at WS toe.

Concrete headwall on LS toe.

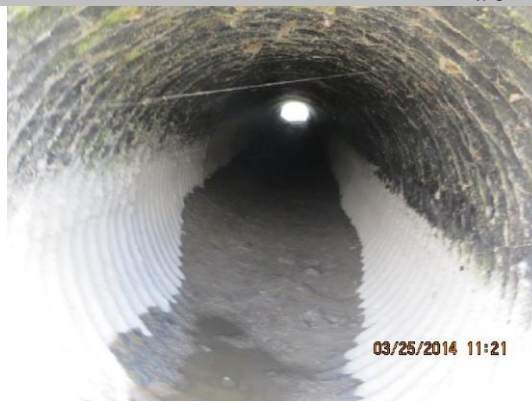
Photo 3 of 3 : UCIP\_SP\_2021\_62497\_59319.jpg

Inside pipe on LS toe.

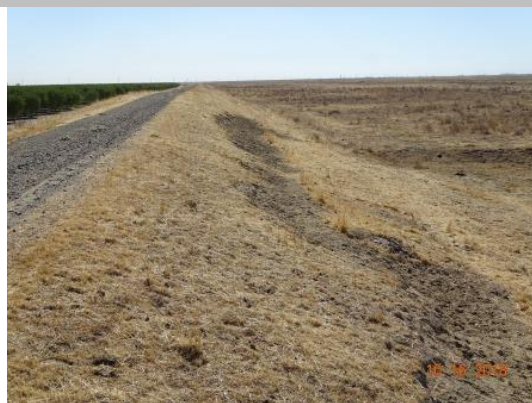
Photo 1 of 1 : SP\_2021\_NA0010\_123\_161\_20210308\_00044.jpg

LM Start	26.19	Rating **	M	Issue No.	161
LM End	26.21	Issue Type +	Ma	Location *	WS
Category	Earthen Levee			GPS Latitude/Longitude	
				Start	End
Item	Animal Control			37.040289 °	37.040043 °
				-120.482988 °	-120.482795 °
DWR ID	DWR_NA0010_05_f_2018_161				
Comment Code					
A2 : Repair the levee slope damaged by livestock and prevent large animal access.					
Inspector Comment					
Waterside slope damage is caused by livestock foot traffic.

Slope damage on waterside. (Fall 2018)

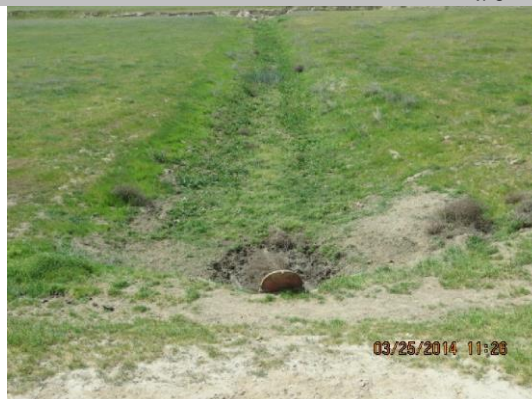
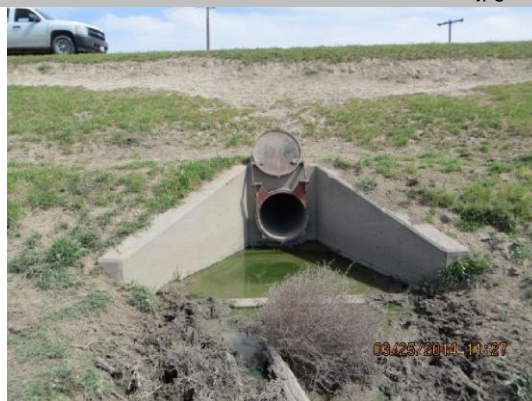
Comment Code						
Inspector Comment						
FS_ID:62498						
DS_ID:19806						
EP_NO: N/A						
Repair Type: Non-Urgent						
Crossing Status: Found						
UCIP Comments: 03/25/2014 Sediment buildup in pipe visible from landward side--recommend contacting owner to clear pipe. (W. Wylie - DWR UCIP)						
FIELD_STRUCT_DESC: 24-inch corrugated metal gravity drainage pipe through the levee, 10 feet below the crown. Flap gate on the waterside (WS) end. Concrete headwall on the landside (LS) end. Concrete U-shaped headwall on the WS end. [Additional Reference(s): DWR Levee Log, 2002 (HLM 26.10), listed as a 24-inch corrugated metal pipe (CMP). USACE San Joaquin O&M Manual, Unit 601 Part 1 (SJR601.1), 1967, Revised 25 May 2011, (HLM 26.11), listed as a 24-inch CMP]						
FS Date: 3/25/2014

Concrete headwall on WS toe.

Flapgate on Concrete headwall at WS toe.

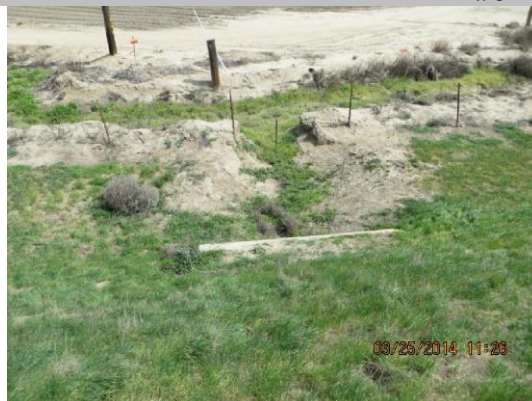
Photo 3 of 3 : UCIP\_SP\_2021\_62498\_59342.jpg

Concrete headwall on LS toe.

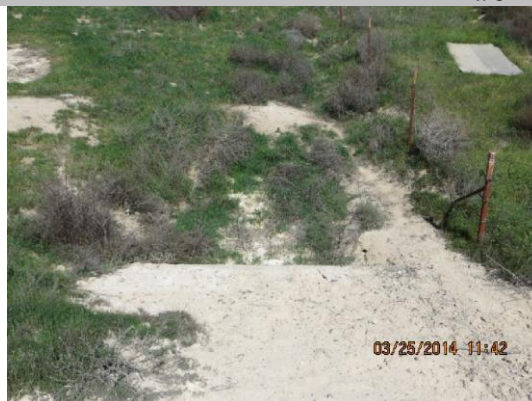
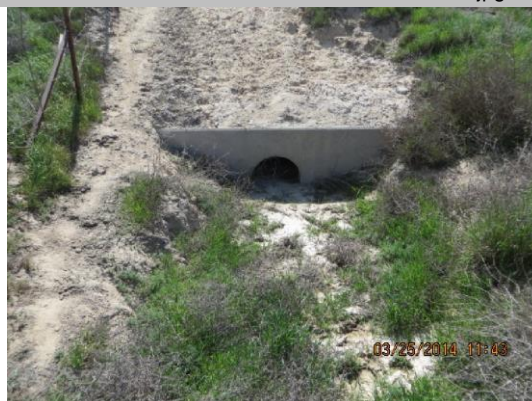
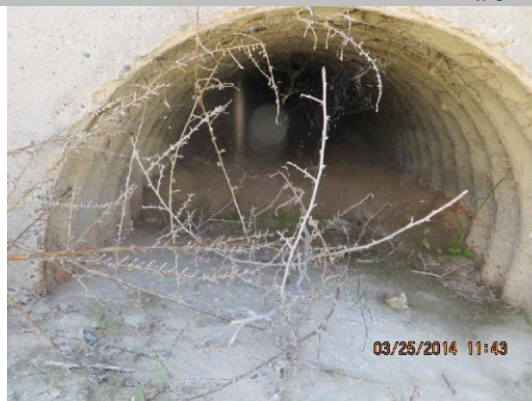
Comment Code						
Inspector Comment						
FS_ID:62500						
DS_ID:19808						
EP_NO: N/A						
Repair Type: Non-Urgent						
Crossing Status: Found						
UCIP Comments: 03/25/2014 Pipe has heavy silt buildup visible from landward side--recommend contacting owner to clear pipe. (W. Wylie - DWR UCIP)						
FIELD_STRUCT_DESC: 24-inch corrugated metal gravity drainage pipe through the levee, 11.4 feet below the crown. Flap gate on the waterside (WS) end. Concrete headwall on the landside (LS) end. Concrete U-shaped headwall on the WS end. [Additional Reference(s): DWR Levee Log, 2002 (HLM 26.85), listed as a 24-inch corrugated metal pipe (CMP). USACE San Joaquin O&M Manual, Unit 601 Part 1 (SJR601.1), 1967, Revised 25 May 2011, (HLM 26.85), listed as a 24-inch CMP]						
FS Date: 3/25/2014

Concrete headwall on LS toe.

Silt buildup in pipe at LS toe.

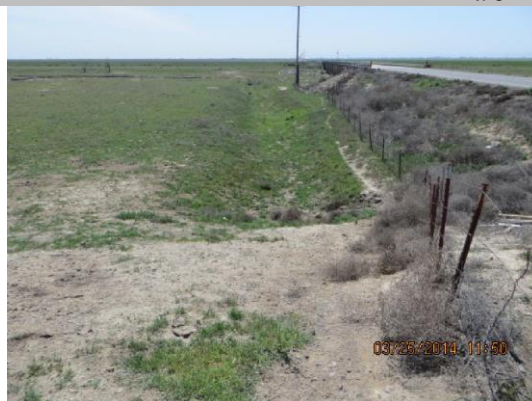
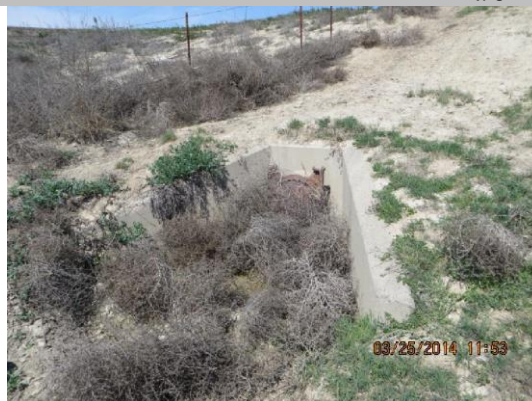
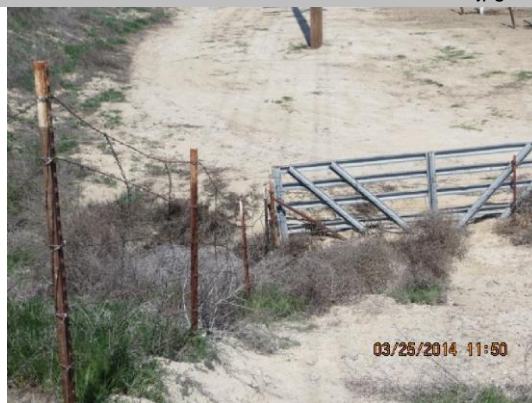
FS\_ID:62501  
 DS\_ID:19748  
 EP\_NO: N/A  
 Repair Type: Non-Urgent  
 Crossing Status: Found  
 UCIP Comments: 03/25/2014 Tumble weed buildup at inlet mat create blockage and should be removed. (W. Wylie - DWR UCIP)  
 FIELD\_STRUCT\_DESC: 24-inch corrugated metal gravity drainage pipe through the levee, 11.3 feet below the crown. Flap gate on the waterside (WS) end. Concrete headwall on the landside (LS) end. Concrete U-shaped headwall on the WS end. [Additional Reference(s): DWR Levee Log, 2002 (HLM 26.87), listed as a 24-inch corrugated metal pipe (CMP). USACE San Joaquin O&M Manual, Unit 601 Part 1 (SJR601.1), 1967, Revised 25 May 2011, (HLM 26.87), listed as a 24-inch CMP]  
 FS Date: 3/25/2014

Concrete headwall at WS toe.

Flapgate and Concrete headwall at WS toe.

Concrete headwall at LS toe.

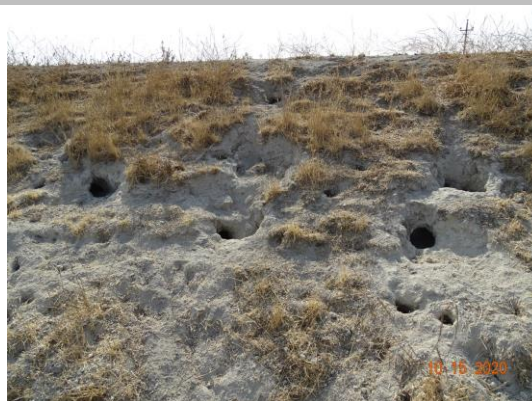
Photo 1 of 1 : SP\_2021\_NA0010\_123\_162\_20210308\_00045.jpg

LM Start	26.99	Rating **	U	Issue No.	162
LM End	27.04	Issue Type +	Ma	Location *	LS
Category	Earthen Levee			GPS Latitude/Longitude	
				Start	End
Item	Animal Control			37.032651 °	37.032659 °
				-120.473205 °	-120.472190 °
DWR ID	DWR_NA0010_05_f_2018_162				
Comment Code					
A1 : Exterminate rodents and backfill and compact or grout burrows.					
Inspector Comment					
Several rodent burrows with large quantities of material displaced noted in this section.

Several rodent burrows noted in this section of the levee. (Fall 2020)

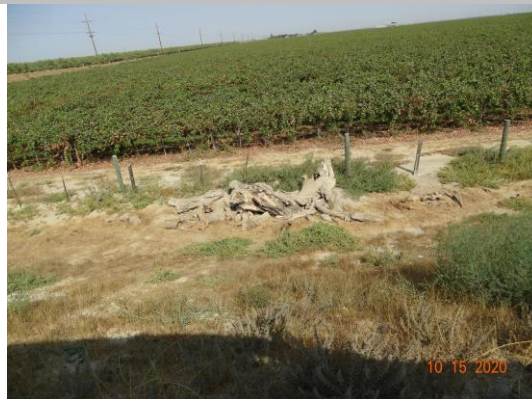
Photo 1 of 1 : SP\_2021\_NA0010\_123\_125\_20210308\_00021.jpg

LM Start	27.01	Rating **	M	Issue No.	125
LM End	27.01	Issue Type +	Ma	Location *	LS
Category	Earthen Levee			GPS Latitude/Longitude	
				Start	End
Item	Encroachments			37.032675 °	37.032675 °
				-120.472841 °	-120.472841 °
DWR ID	DWR_NA0010_05_s_2021_125				
Comment Code					
TR : Tree or limb					
Inspector Comment

Prunings left on the landside toe. (Fall 2020)

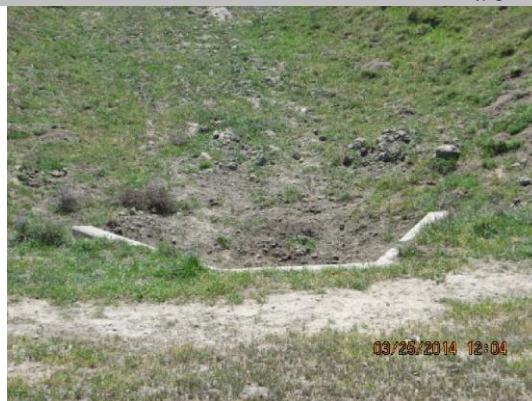
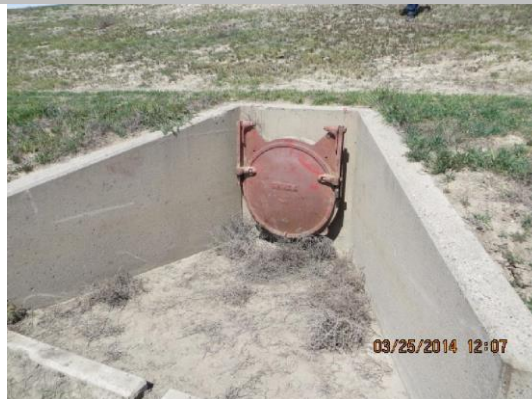
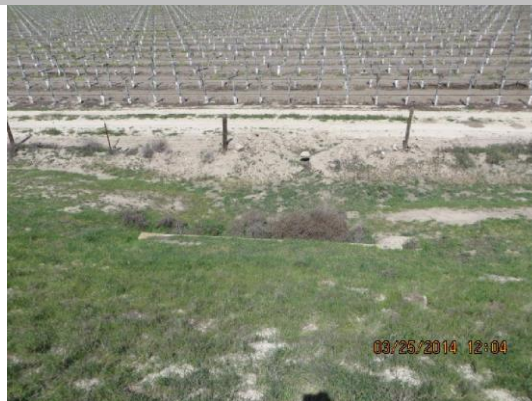
LM Start	27.31	Rating **	A/W	Issue No.	85	
LM End	27.31	Issue Type +	Ma	Location *		
Category	Supplemental			GPS Latitude/Longitude		
				Start	End	
Item	DWR UCIP LMA Responsibility			37.032668 °	37.032668 °	
				-120.467299 °	-120.467299 °	
DWR ID	19749					
Comment Code						
Inspector Comment						
FS_ID:62502 DS_ID:19749 EP_NO: N/A Repair Type: No Action Needed Crossing Status: Found UCIP Comments: FIELD_STRUCT_DESC: 36-inch corrugated metal gravity drainage pipe through the levee, 12 feet below the crown. Flap gate on the waterside (WS) end. Concrete headwall on the landside (LS) end. Concrete U-shaped headwall on the WS end. [Additional Reference(s): DWR Levee Log, 2002 (HLM 27.21), listed as a 36-inch corrugated metal pipe (CMP). USACE San Joaquin O&M Manual, Unit 601 Part 1 (SJR601.1), 1967, Revised 25 May 2011, (HLM 27.22), listed as a 36-inch CMP] FS Date: 3/25/2014

Concrete headwall on WS toe.

Flapgate at Concrete headwall on WS toe.

Concrete headwall on LS toe.

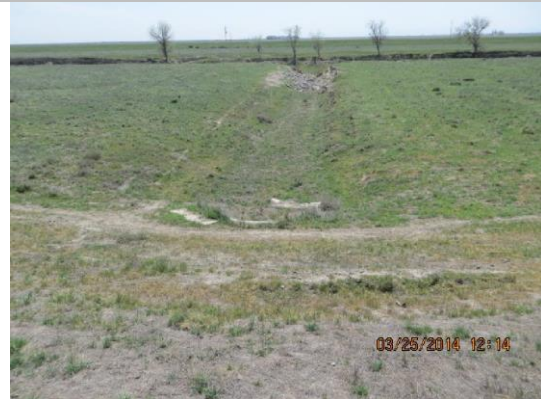
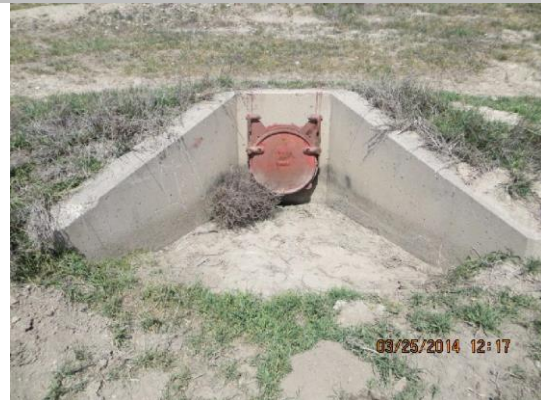
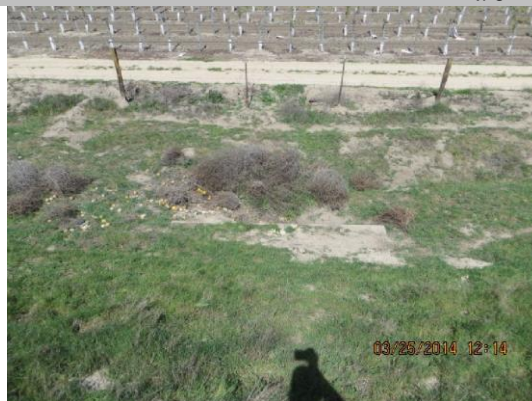
Comment Code						
Inspector Comment						
FS_ID:62503 DS_ID:19750 EP_NO: N/A Repair Type: Non-Urgent Crossing Status: Found UCIP Comments: 03/25/2014 Animal Burrowing activity at LS toe may undermine headwall. (W. Wylie - DWR UCIP) FIELD_STRUCT_DESC: 24-inch corrugated metal gravity drainage pipe through the levee, 10.8 feet below the crown. Flap gate on the waterside (WS) end. Concrete headwall on the landside (LS) end. Concrete U-shaped headwall on the WS end. [Additional Reference(s): DWR Levee Log, 2002 (HLM 28.17), listed as a 24-inch corrugated metal pipe (CMP). USACE San Joaquin O&M Manual, Unit 601 Part 1 (SJR601.1), 1967, Revised 25 May 2011, (HLM 28.17), listed as a 24-inch CMP] FS Date: 3/25/2014

Concrete headwall on WS toe.

Flapgate on Concrete headwall at WS toe.

Concrete headwall on LS toe.

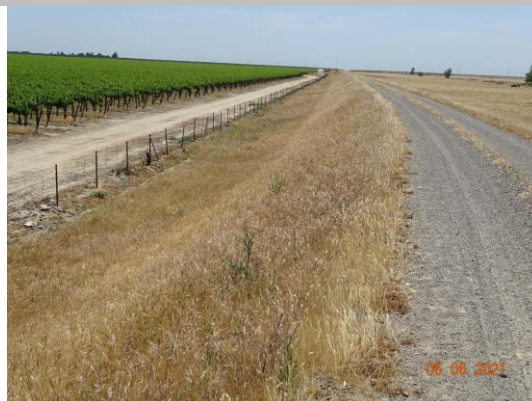
Photo 1 of 1 : SP\_2021\_NA0010\_123\_149\_20210517\_00326.jpg

LM Start	28.77	Rating **	M	Issue No.	149
LM End	30.55	Issue Type +	Ma	Location *	LS
Category	Earthen Levee			GPS Latitude/Longitude	
				Start	End
Item	Vegetation			37.031956 °	37.009507 °
				-120.441370 °	-120.425662 °
DWR ID	DWR_NA0010_05_s_2021_149				
Comment Code					
V1 : Control annual grass and weeds on the levee slopes and easements.					
Inspector Comment

View of vegetation on the landside slope and toe. (Spring 2021)

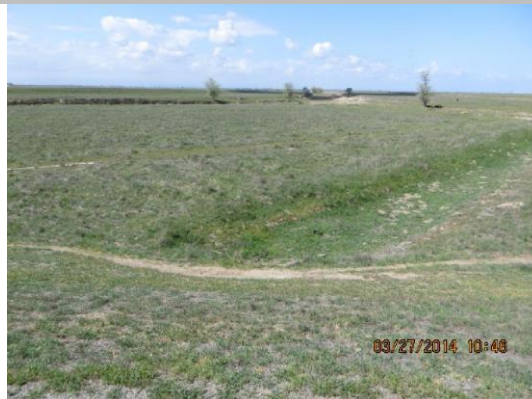
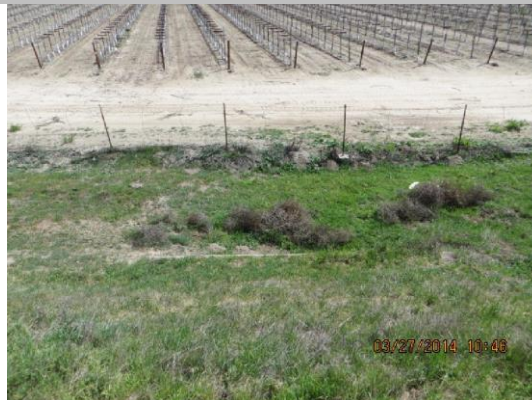
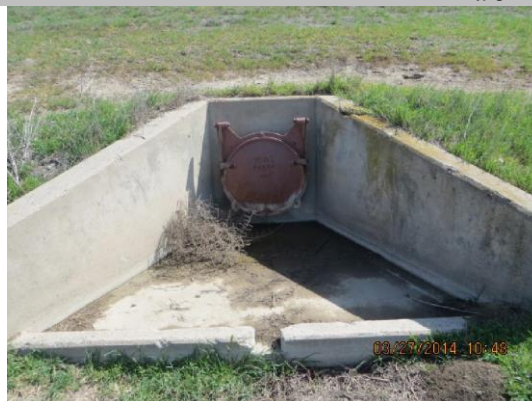
LM Start	28.79	Rating **	A/W	Issue No.	87
LM End	28.79	Issue Type +	Ma	Location *	
Category	Supplemental			GPS Latitude/Longitude	
				Start	End
Item	DWR UCIP LMA Responsibility			37.031640 °	37.031640 °
				-120.441389 °	-120.441389 °
DWR ID	19751				
Comment Code					
Inspector Comment					
FS_ID:62504 DS_ID:19751 EP_NO: N/A Repair Type: No Action Needed Crossing Status: Found UCIP Comments: FIELD_STRUCT_DESC: 30-inch corrugated metal gravity drainage pipe through the levee, 9.8 feet below the crown. Flap gate on the waterside (WS) end. Concrete headwall on the landside (LS) end. Concrete U-shaped headwall on the WS end. [Additional Reference(s): DWR Levee Log, 2002 (HLM 28.69), listed as a 30-inch corrugated metal pipe (CMP). USACE San Joaquin O&M Manual, Unit 601 Part 1 (SJR601.1), 1967, Revised 25 May 2011, (HLM 28.69), listed as a 30-inch CMP] FS Date: 3/27/2014

Concrete headwall on WS toe.

Concrete headwall on LS toe.

Flapgate on Concrete headwall at WS toe.

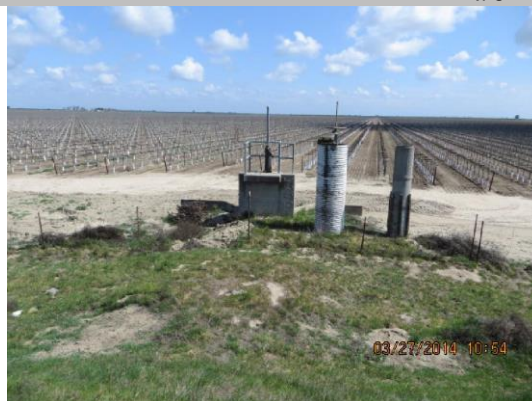
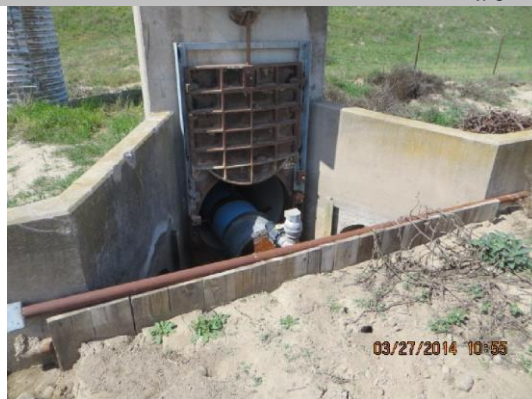
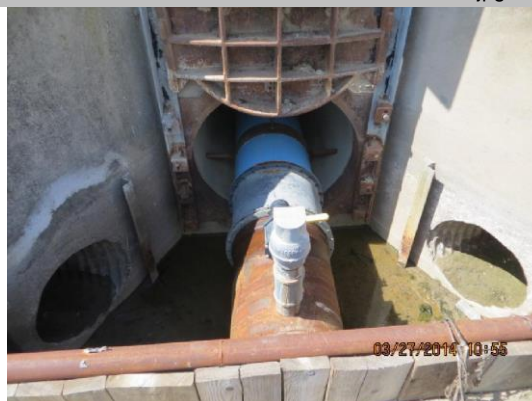
FS\_ID:62505  
DS\_ID:19752  
EP\_NO: N/A  
Repair Type: Non-Urgent  
Crossing Status: Found  
UCIP Comments: 7/20/2016 same as previous inspection. Crossing has been downgraded from Urgent to Non-Urgent slide gate is on LS. Pipe is buried through WS. Need to coordinate with owner to determine permit used to authorized sleeved pipe. (O. Magana - DWR UCIP)3/27/2014 Slide gate will not close due to 24-inch PVC pipe sleeved through pipe. Also slide gate rails rusted beyond use. (W. Wylie - DWR UCIP)  
FIELD\_STRUCT\_DESC: [Rodunder Siphon Structure] 48-inch reinforced concrete irrigation siphon pipe through the levee, 12.1 feet below the crown. Concrete U-shaped headwall on inlet structure on the landside (LS) end. Slide gate mounted on concrete headwall on the LS. 36-inch corrugated metal pipe (CMP) riser with a slide gate on the LS, 8 feet upstream from the siphon. 24-inch pipe from this unit enters the siphon behind the inlet structure. [Additional Reference(s): DWR Levee Log, 2002 (HLM 28.95), listed as a 48-inch reinforced concrete pipe (RCP). USACE San Joaquin O&M Manual, Unit 601 Part 1 (SJR601.1), 1967, Revised 25 May 2011, (HLM 28.95), listed as a 48-inch RCP referenced as Rodunder Siphon]

Slide gate mounted to concrete headwall on LS toe.

24-inch PVC pipe sleeved through 48-inch concrete pipe.

24-inch PVC pipe sleeved through 48-inch concrete pipe. Rails on Slide gate rusted beyond use.

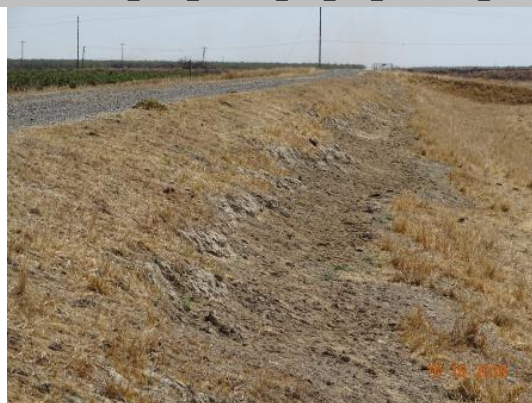
Photo 1 of 1 : SP\_2021\_NA0010\_123\_164\_20210308\_00046.jpg

LM Start	29.43	Rating **	M	Issue No.	164
LM End	29.56	Issue Type +	Ma	Location *	WS
Category	Earthen Levee			GPS Latitude/Longitude	
				Start	End
Item	Animal Control			37.023481 °	37.021794 °
				-120.435960 °	-120.434769 °
DWR ID	DWR_NA0010_05_f_2018_164				
Comment Code					
A2 : Repair the levee slope damaged by livestock and prevent large animal access.					
Inspector Comment					
There is slope damage on waterside from livestock traffic.

Slope damage from animal traffic. (Fall 2018)

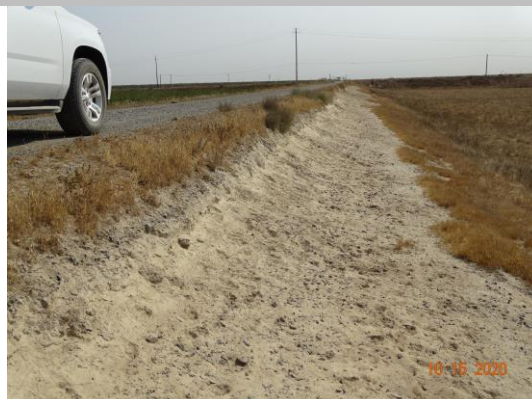
Photo 1 of 1 : SP\_2021\_NA0010\_123\_171\_20210308\_00047.jpg

LM Start	29.58	Rating **	M	Issue No.	171
LM End	29.80	Issue Type +	Ma	Location *	WS
Category	Earthen Levee			GPS Latitude/Longitude	
				Start	End
Item	Animal Control			37.021534 °	37.018712 °
				-120.434592 °	-120.432682 °
DWR ID	DWR_NA0010_05_s_2014_171				
Comment Code					
A2 : Repair the levee slope damaged by livestock and prevent large animal access.					
Inspector Comment					
There is waterside erosion caused by livestock.

Looking south at livestock erosion on the waterside slope. (Fall 2020)

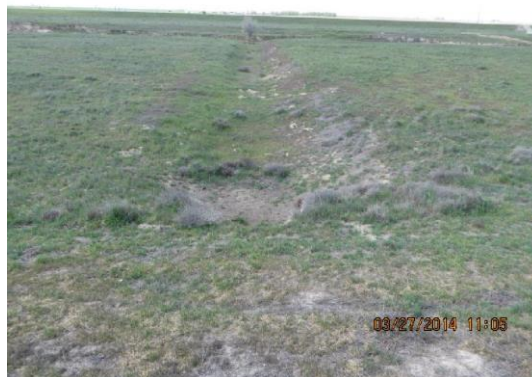
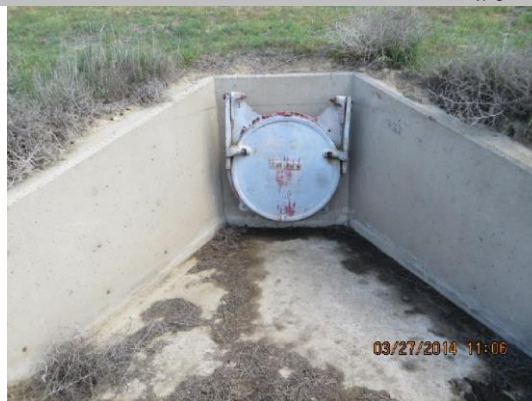
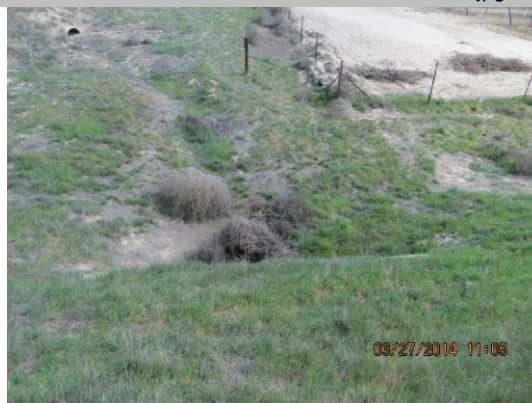
Comment Code					
Inspector Comment					
FS_ID:62510 DS_ID:19753 EP_NO: N/A Repair Type: Non-Urgent Crossing Status: Found UCIP Comments: 03/27/2014 Dense vegetation limits the inspector's visibility to identify signs of pipe failure (leaks) along the landward slope. Recommend removing vegetation along pipe alignment to conduct proper inspection of structure. Sediment buildup in pipe visible from landward side--recommend contacting owner to clear pipe. (W. Wylie - DWR UCIP) FIELD_STRUCT_DESC: 36-inch corrugated metal gravity drainage pipe through the levee, 10.2 feet below the crown. Flap gate on the waterside (WS) end. Concrete headwall on the landside (LS) end. Concrete U-shaped headwall on the WS end. [Additional Reference(s): DWR Levee Log, 2002 (HLM 29.49), listed as a 36-inch corrugated metal pipe (CMP). USACE San Joaquin O&M Manual, Unit 601 Part 1 (SJR601.1), 1967, Revised 25 May 2011, (HLM 29.49), listed as a 36-inch CMP] FS Date: 3/27/2014

Concrete headwall on WS toe.

Flapgate on Concrete headwall at WS toe.

Concrete headwall on LS toe.

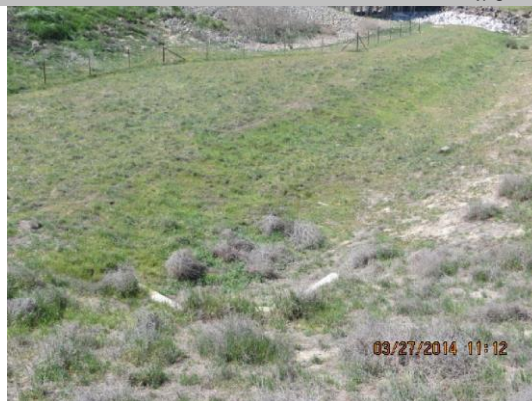
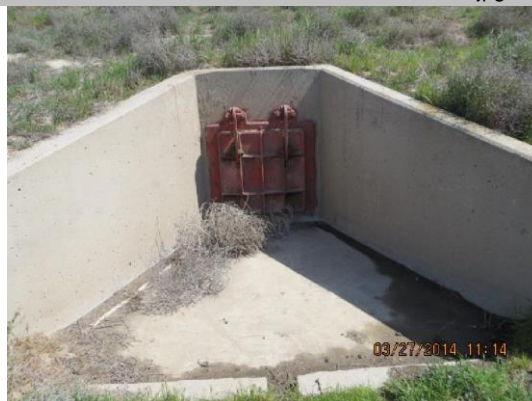
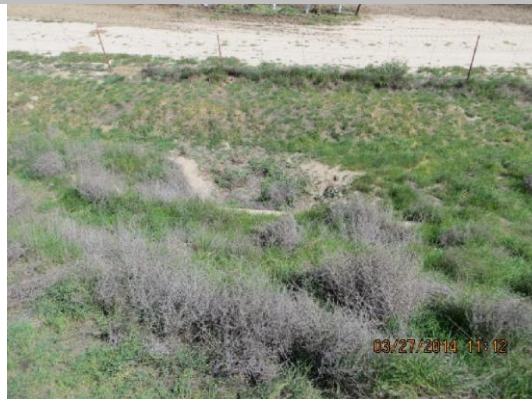
FS\_ID:62511  
DS\_ID:19754  
EP\_NO: N/A  
Repair Type: Non-Urgent  
Crossing Status: Found  
UCIP Comments: 03/27/2014 Dense vegetation limits the inspector's visibility to identify signs of pipe failure (leaks) along the landward slope. Recommend removing vegetation along pipe alignment to conduct proper inspection of structure. (W. Wylie - DWR UCIP)  
FIELD\_STRUCT\_DESC: 30-inch by 30-inch reinforced concrete box gravity drainage culvert through the levee, 12 feet below the crown. Flap gate on the waterside (WS) end. Concrete headwall on the landside (LS) end. Concrete U-shaped headwall on the WS end.  
[Additional Reference(s): DWR Levee Log, 2002 (HLM 29.72), listed as a 30-inch square reinforced concrete box culvert (RCBC). USACE San Joaquin O&M Manual, Unit 601 Part 1 (SJR601.1), 1967, Revised 25 May 2011, (HLM 29.72), listed as a 2.5-feet by 2.5-feet RCBC]  
FS Date: 3/27/2014

Concrete headwall on WS toe.

Flapgate on Concrete headwall at WS toe.

Concrete headwall on LS toe.

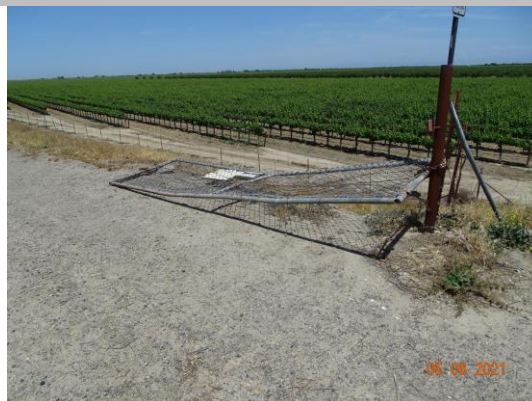
Photo 1 of 1 : SP\_2021\_NA0010\_123\_151\_20210517\_00327.jpg

LM Start	29.83	Rating **	U	Issue No.	151
LM End	29.83	Issue Type +	Ma	Location *	CR
Category	Earthen Levee			GPS Latitude/Longitude	
				Start	End
Item	Repair Gates			37.018351 °	37.018351 °
				-120.432399 °	-120.432399 °
DWR ID	DWR_NA0010_05_s_2021_151				
Comment Code					
Inspector Comment					
Broken access gate should be repaired or replaced.

Broken access gate at Avenue 18 1/2 crossing of the levee. (Spring 2021)

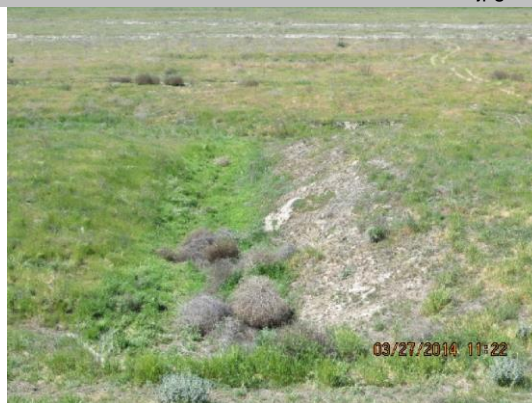
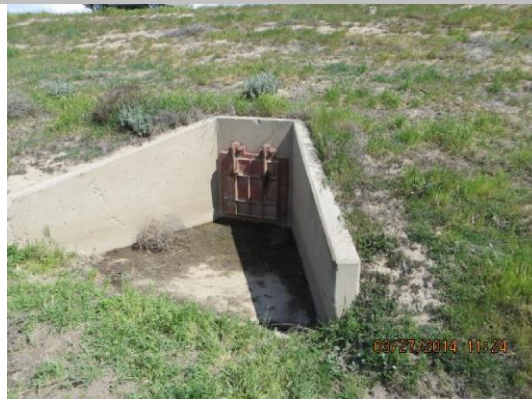
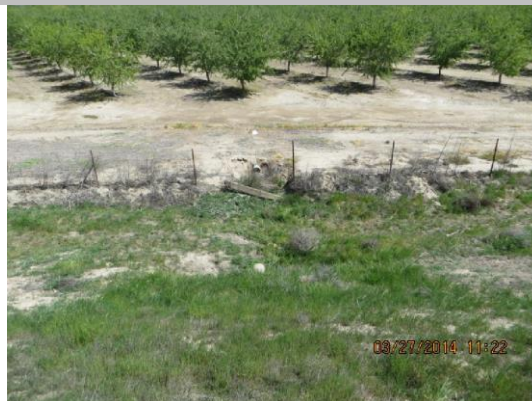
Comment Code						
Inspector Comment						
FS_ID:62512						
DS_ID:19696						
EP_NO: N/A						
Repair Type: Non-Urgent						
Crossing Status: Found						
UCIP Comments: 03/27/2014 Dense vegetation limits the inspector's visibility to identify signs of pipe failure (leaks) along the landward slope. Recommend removing vegetation along pipe alignment to conduct proper inspection of structure. (W. Wylie - DWR UCIP)						
FIELD_STRUCT_DESC: 30-inch by 30-inch reinforced concrete box gravity drainage culvert through the levee, 13.1 feet below the crown. Flap gate on the waterside (WS) end. Concrete headwall on the landside (LS) end. Concrete U-shaped headwall on the WS end.						
[Additional Reference(s): DWR Levee Log, 2002 (HLM 30.04), listed as a 30-inch square reinforced concrete box culvert (RCBC). USACE San Joaquin O&M Manual, Unit 601 Part 1 (SJR601.1), 1967, Revised 25 May 2011, (HLM 30.04), listed as a 2.5-feet by 2.5-feet RCBC]

Concrete headwall on WS toe.

Flapgate on Concrete headwall at WS toe.

Concrete headwall on LS toe.

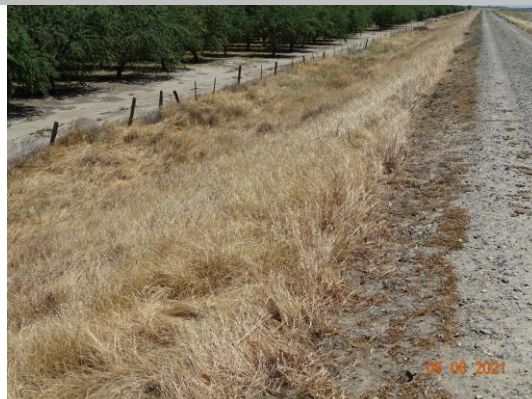
Photo 1 of 1 : SP\_2021\_NA0010\_123\_154\_20210517\_00328.jpg

LM Start	30.55	Rating **	U	Issue No.	154
LM End	31.28	Issue Type +	Ma	Location *	LS
Category	Earthen Levee			GPS Latitude/Longitude	
				Start	End
Item	Vegetation			37.009505 °	37.001889 °
				-120.425660 °	-120.416398 °
DWR ID	DWR_NA0010_05_s_2021_154				
Comment Code					
V1 : Control annual grass and weeds on the levee slopes and easements.					
Inspector Comment

Looking upstream along the landside slope. (Spring 2021)

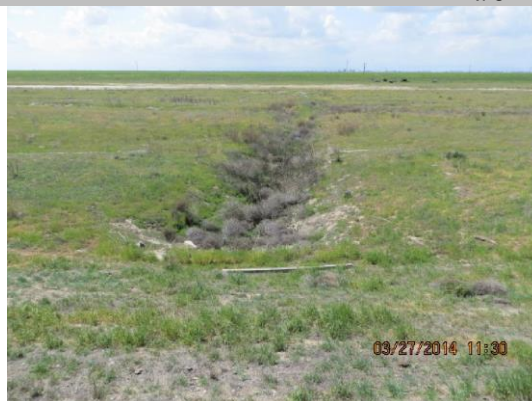
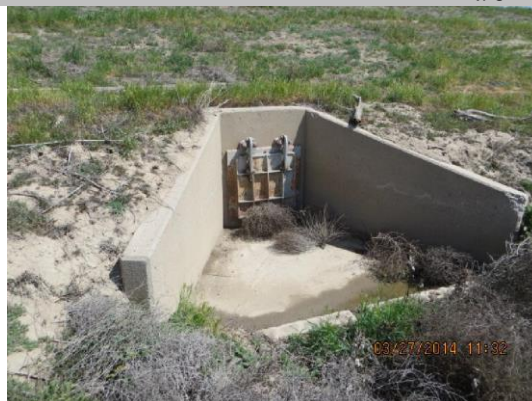
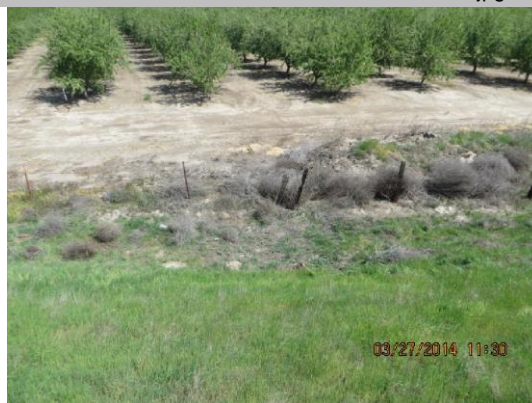
Photo 1 of 3 : UCIP\_SP\_2021\_62513\_59435.jpg

Comment Code					
Inspector Comment					
FS_ID:62513 DS_ID:19697 EP_NO: N/A Repair Type: Non-Urgent Crossing Status: Found UCIP Comments: 03/27/2014 Some debris buildup at LS toe. Dense vegetation limits the inspector's visibility to identify signs of pipe failure (leaks) along the landward slope. Recommend removing vegetation along pipe alignment to conduct proper inspection of structure. (W. Wylie - DWR UCIP) FIELD_STRUCT_DESC: 30-inch by 30-inch reinforced concrete box gravity drainage culvert through the levee, 13.3 feet below the crown. Flap gate on the waterside (WS) end. Concrete headwall on the landside (LS) end. Concrete U-shaped headwall on the WS end. [Additional Reference(s): DWR Levee Log, 2002 (HLM 30.97), listed as a 30-inch square reinforced concrete box culvert (RCBC). USACE San Joaquin O&M Manual, Unit 601 Part 1 (SJR601.1), 1967, Revised 25 May 2011, (HLM 30.96), listed as a 2.5-feet by 2.5-feet RCBC] FS Date: 3/27/2014

Concrete headwall on WS toe.

Flapgate on Concrete headwall at WS toe.

Concrete headwall on LS toe.

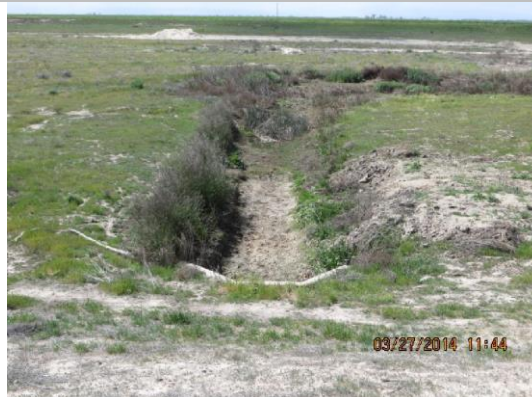
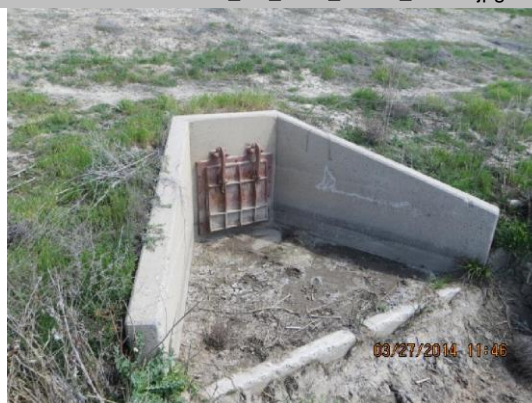
Photo 1 of 3 : UCIP\_SP\_2021\_62514\_59439.jpg

FS\_ID:62514  
DS\_ID:19698  
EP\_NO: N/A  
Repair Type: Non-Urgent  
Crossing Status: Found  
UCIP Comments: 03/27/2014 Excess vegetation buildup at inlet on LS toe. Dense vegetation limits the inspector's visibility to identify signs of pipe failure (leaks) along the landward slope. Recommend removing vegetation along pipe alignment to conduct proper inspection of structure. (W. Wylie - DWR UCIP)  
FIELD\_STRUCT\_DESC: 30-inch by 30-inch reinforced concrete box gravity drainage culvert through the levee, 13.4 feet below the crown. Flap gate on the waterside (WS) end. Concrete headwall on the landside (LS) end. Concrete U-shaped headwall on the WS end.  
[Additional Reference(s): DWR Levee Log, 2002 (HLM 31.20), listed as a 30-inch square reinforced concrete box culvert (RCBC). USACE San Joaquin O&M Manual, Unit 601 Part 1 (SJR601.1), 1967, Revised 25 May 2011, (HLM 31.19), listed as a 2.5-feet by 2.5-feet RCBC]

Concrete headwall on WS toe.

Flapgate at concrete headwall on WS toe.

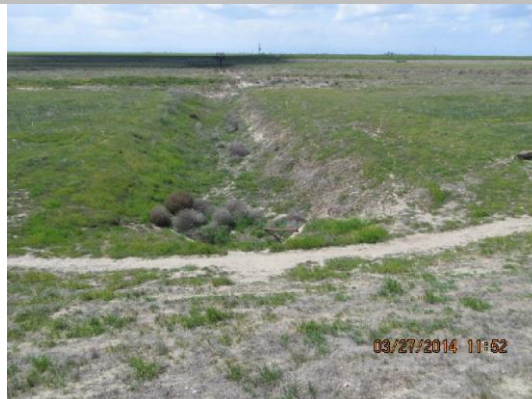
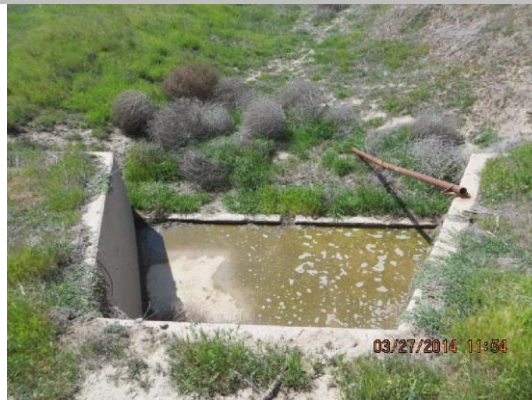
Photo 1 of 3 : UCIP\_SP\_2021\_62515\_59444.jpg

LM Start	31.74	Rating **	A/W	Issue No.	94
LM End	31.74	Issue Type +	Ma	Location *	
Category	Supplemental			GPS Latitude/Longitude	
				Start	End
Item	DWR UCIP LMA Responsibility			36.997001 °	36.997001 °
				-120.410991 °	-120.410991 °
DWR ID	19699				
Comment Code					
Inspector Comment					
FS_ID:62515 DS_ID:19699 EP_NO: N/A Repair Type: No Action Needed Crossing Status: Found UCIP Comments: FIELD_STRUCT_DESC: 48-inch by 36-inch reinforced concrete box gravity drainage culvert through the levee, 14.5 feet below the crown. Flap gate on the waterside (WS) end. Concrete U-shaped headwall on each end. [Additional Reference(s): DWR Levee Log, 2002 (HLM 31.64), listed as a 48-inch by 36-inch reinforced concrete box culvert (RCBC). USACE San Joaquin O&M Manual, Unit 601 Part 1 (SJR601.1), 1967, Revised 25 May 2011, (HLM 31.64), listed as a 4-feet by 3-feet RCBC] FS Date: 3/27/2014

Concrete headwall on WS toe.

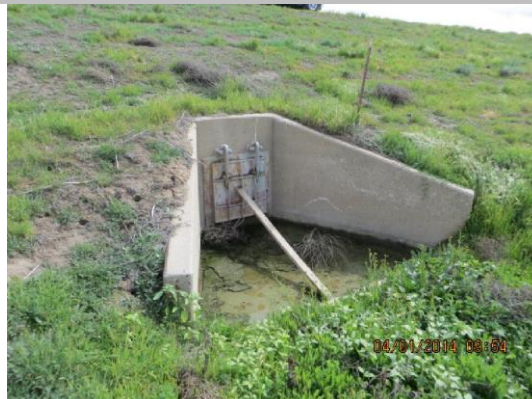
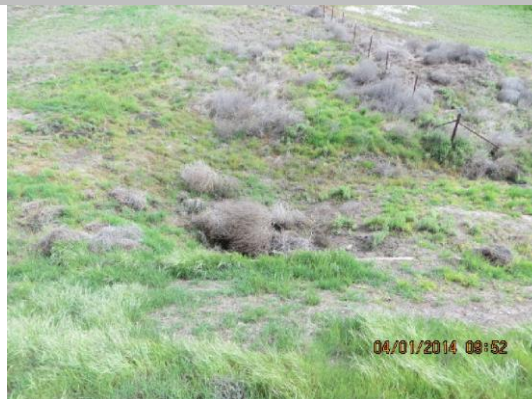
Photo 2 of 3 : UCIP\_SP\_2021\_62506\_59687.jpg

Flapgate on Concrete headwall at channel on WS toe.

Concrete headwall on LS toe.

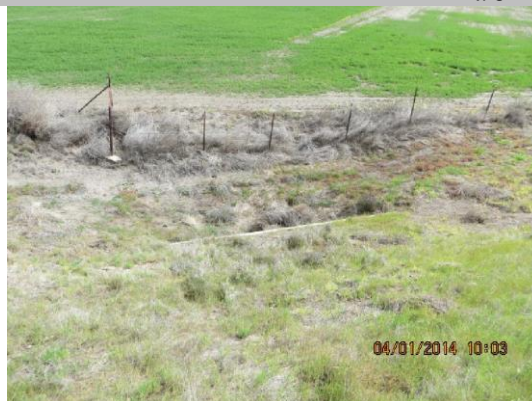
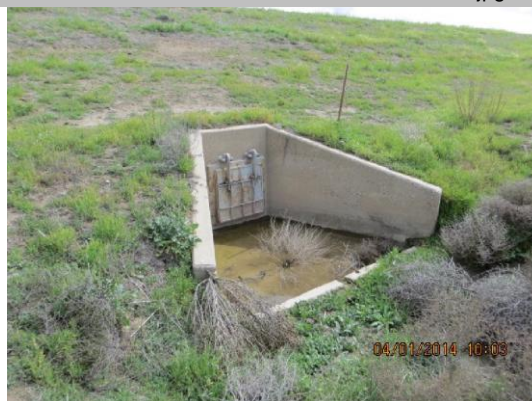
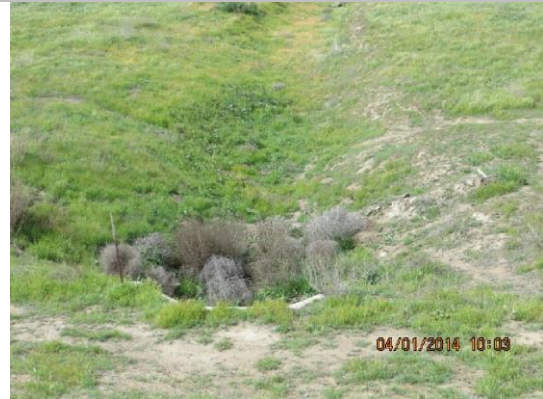
Photo 1 of 3 : UCIP\_SP\_2021\_62507\_59690.jpg

FS\_ID:62507  
DS\_ID:19701  
EP\_NO: N/A  
Repair Type: Non-Urgent  
Crossing Status: Found  
UCIP Comments: 04/01/2014 Some silt buildup inside culvert. (W. Wylie - DWR UCIP)  
FIELD\_STRUCT\_DESC: 30-inch by 30-inch reinforced concrete box gravity drainage culvert through the levee, 14.2 feet below the crown. Flap gate on the waterside (WS) end. Concrete headwall on the landside (LS) end with flashboard attachment. Concrete U-shaped headwall on the WS end. [Additional Reference(s): DWR Levee Log, 2002 (HLM 32.22), listed as a 30-inch square reinforced concrete box culvert (RCBC). USACE San Joaquin O&M Manual, Unit 601 Part 1 (SJR601.1), 1967, Revised 25 May 2011, (HLM 32.22), listed as a 2.6-feet by 2.6-feet RCBC]  
FS Date: 4/1/2014

Concrete headwall at inlet on LS toe.

Flapgate on Concrete headwall at WS toe.

Concrete headwall at outlet on WS toe.

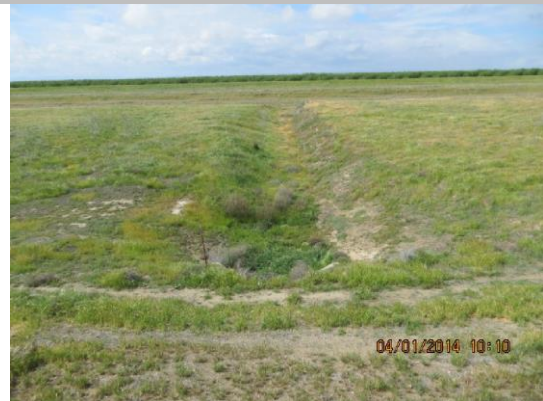
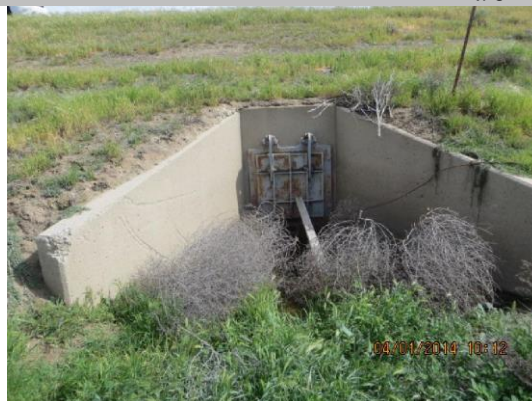
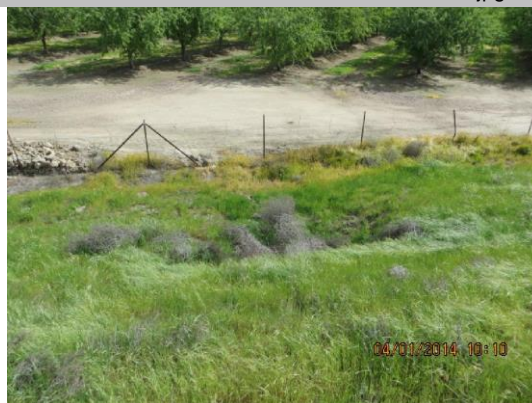
Photo 1 of 3 : UCIP\_SP\_2021\_62508\_59697.jpg

FS\_ID:62508  
DS\_ID:19702  
EP\_NO: N/A  
Repair Type: Non-Urgent  
Crossing Status: Found  
UCIP Comments: 04/01/2014 Dense vegetation limits the inspector's visibility to identify signs of pipe failure (leaks) along the landward slope. Recommend removing vegetation along pipe alignment to conduct proper inspection of structure. Debris buildup blocking landward headwall--recommend contacting owner to clear debris. (W. Wylie - DWR UCIP)  
FIELD\_STRUCT\_DESC: 30-inch by 30-inch reinforced concrete box gravity drainage culvert through the levee, 12.2 feet below the crown. Flap gate on the waterside (WS) end. Concrete headwall on the landside (LS) end. Concrete U-shaped headwall on the WS end.  
[Additional Reference(s): DWR Levee Log, 2002 (HLM 33.02), listed as a 30-inch square reinforced concrete box culvert (RCBC). USACE San Joaquin O&M Manual, Unit 601 Part 1 (SJR601.1), 1967, Revised 25 May 2011, (HLM 33.01), listed as a 2.6-feet by 2.6-feet RCBC]

Concrete headwall at WS toe.

Flapgate on Concrete headwall at WS toe.

Concrete headwall at inlet on LS toe.
