# Flood Control Project Maintenance Levee Inspections LMA District Cover Sheet

## Lower San Joaquin Levee District

**Flood Control Project Maintenance  
Levee Inspections  
Unit Cover Sheet**

Waterway			Bank	Unit Miles
Unit No. 01 San Joaquin River			Right	22.52
	Spring (March - May)	Summer (June - August)	(September - November) Fall	Winter (December - February)
Unit Maintenance Rating (Fall Only)				
Date of Inspection	5/4/2021 - 5/4/2021			
DWR Inspector	Corey Fujitani			
Accompanied By

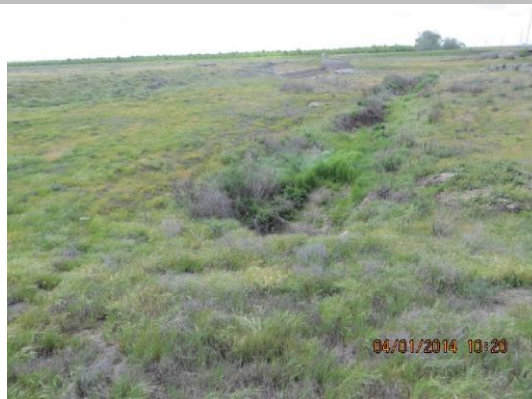
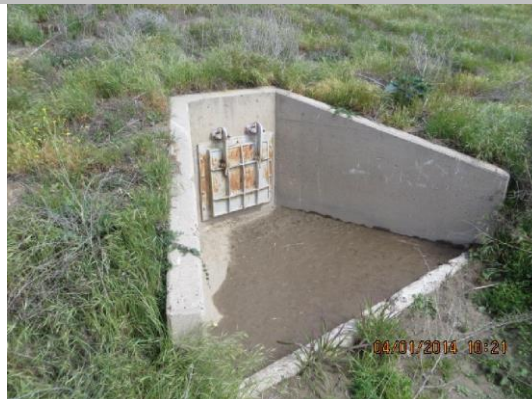
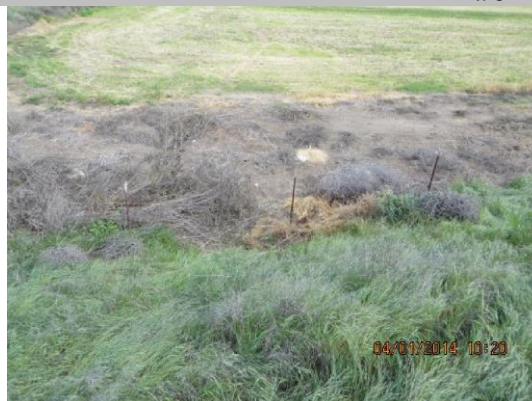
Photo 1 of 3 : UCIP\_SP\_2021\_62509\_59701.jpg

FS\_ID:62509  
DS\_ID:19703  
EP\_NO: N/A  
Repair Type: Non-Urgent  
Crossing Status: Found  
UCIP Comments: 04/01/2014 Dense vegetation limits the inspector's visibility to identify signs of pipe failure (leaks) along the slopes. Recommend removing vegetation along pipe alignment to conduct proper inspection of structure. (W. Wylie - DWR UCIP)  
FIELD\_STRUCT\_DESC: 30-inch by 30-inch reinforced concrete box gravity drainage culvert through the levee, 13.9 feet below the crown. Flap gate on the waterside (WS) end. Concrete headwall on the landside (LS) end. Concrete U-shaped headwall on the WS end.  
[Additional Reference(s): DWR Levee Log, 2002 (HLM 33.72), listed as a 30-inch square reinforced concrete box culvert (RCBC). USACE San Joaquin O&M Manual, Unit 601 Part 1 (SJR601.1), 1967, Revised 25 May 2011, (HLM 33.72), listed as a 2.6-feet by 2.6-feet RCBC]  
FS Date: 4/1/2014

Concrete headwall at WS toe.

Flapgate on Concrete headwall at WS toe.

Concrete headwall at LS toe.

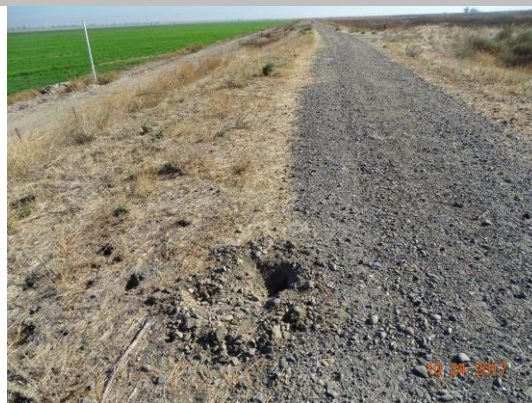
Photo 1 of 1 : SP\_2021\_NA0010\_123\_130\_20210308\_00025.jpg

LM Start	33.82	Rating **	M	Issue No.	130
LM End	33.82	Issue Type +	Ma	Location *	LS
Category	Earthen Levee			GPS Latitude/Longitude	
				Start	End
Item	Animal Control			36.976849 °	36.976849 °
				-120.382393 °	-120.382393 °
DWR ID	DWR_NA0010_05_f_2017_130				
Comment Code					
A3 : No rodents visible, but rodent burrows visible; need to backfill and compact or grout burrows.					
Inspector Comment

Looking east at the landside shoulder.

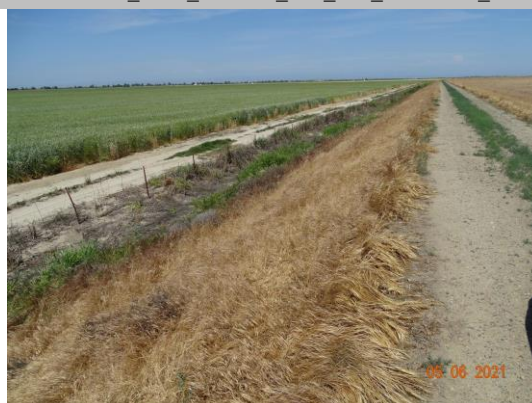
Photo 1 of 1 : SP\_2021\_NA0010\_123\_166\_20210517\_00329.jpg

LM Start	33.92	Rating **	U	Issue No.	166
LM End	34.84	Issue Type +	Ma	Location *	LS
Category	Earthen Levee			GPS Latitude/Longitude	
				Start	End
Item	Vegetation			36.977359 °	36.981430 °
				-120.380601 °	-120.367714 °
DWR ID	DWR_NA0010_05_s_2021_166				
Comment Code					
V1 : Control annual grass and weeds on the levee slopes and easements.					
Inspector Comment

Looking upstream at vegetation along the landside slope. (Spring 2021)

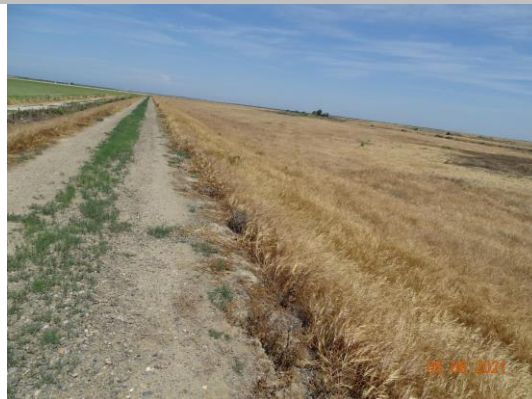
Photo 1 of 1 : SP\_2021\_NA0010\_123\_167\_20210517\_00330.jpg

LM Start	33.92	Rating **	U	Issue No.	167
LM End	34.84	Issue Type +	Ma	Location *	WS
Category	Earthen Levee			GPS Latitude/Longitude	
				Start	End
Item	Vegetation			36.977359 °	36.981430 °
				-120.380601 °	-120.367714 °
DWR ID	DWR_NA0010_05_s_2021_167				
Comment Code					
V1 : Control annual grass and weeds on the levee slopes and easements.					
Inspector Comment

Looking upstream at vegetation on the waterside slope. (Spring 2021)

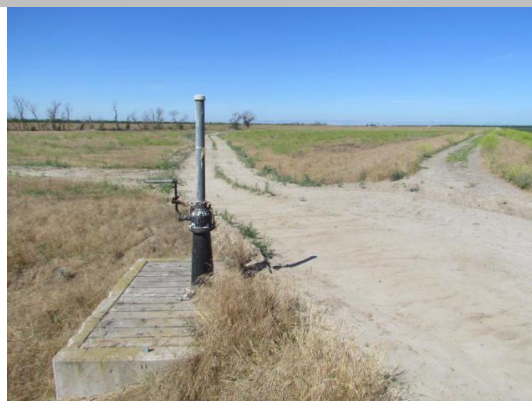
Photo 1 of 1 : SP\_2021\_NA0010\_123\_11\_20210308\_00008.jpg

LM Start	34.61	Rating **	M	Issue No.	11
LM End	34.61	Issue Type +	En	Location *	WS
Category	Earthen Levee			GPS Latitude/Longitude	
				Start	End
Item	Encroachments			36.978523 °	36.978523 °
				-120.368520 °	-120.368520 °
DWR ID	DWR_NA0010_05_s_2012_11				
Comment Code					
RA : Ramp					
Inspector Comment					
There is an unauthorized ramp on waterside slope. Landowner cut unauthorized ramp on waterside slope and levee crown.

Looking west at ramp on waterward slope.

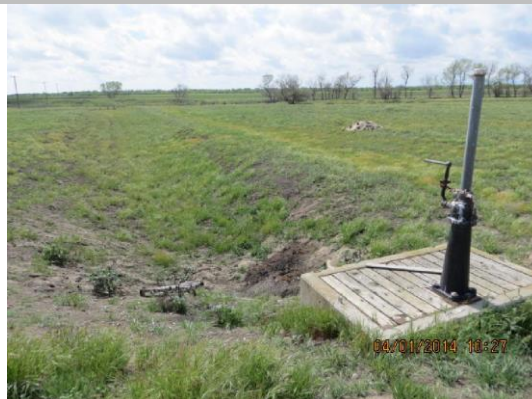
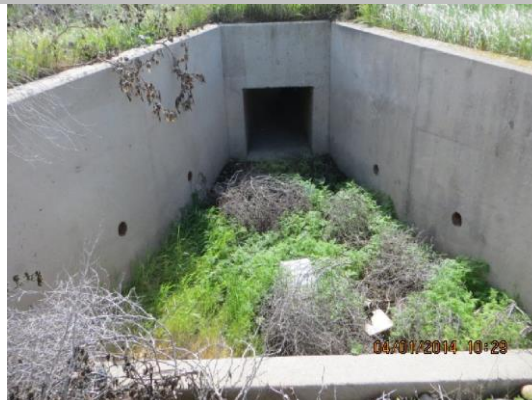
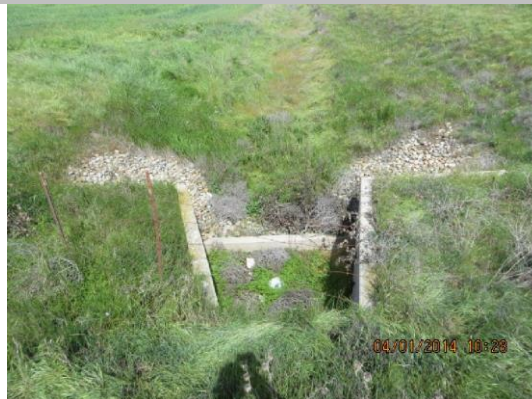
Photo 1 of 3 : UCIP\_SP\_2021\_62525\_59706.jpg

FS\_ID:62525  
DS\_ID:19755  
EP\_NO: N/A  
Repair Type: Non-Urgent  
Crossing Status: Found  
UCIP Comments: 04/01/2014 Dense vegetation limits the inspector's visibility to identify signs of pipe failure (leaks) along the landward slope. Recommend removing vegetation along pipe alignment to conduct proper inspection of structure. Debris buildup visible on waterward headwall--recommend contacting owner to clear pipe. (W. Wylie - DWR UCIP)  
FIELD\_STRUCT\_DESC: [Chowchilla Canal Irrigation Structure] 36-inch by 36-inch reinforced concrete box gravity irrigation culvert through the levee, 9.7 feet below the crown. Slide gate in a 56-inch by 91-inch concrete riser on the waterside (WS) slope. Concrete U-shaped headwall on each end. Landside channel cobble revetted for 8 feet.  
[Additional Reference(s): DWR Levee Log, 2002 (HLM 34.51), listed as a 36-inch square reinforced concrete box culvert (RCBC) referenced as the Chowchilla Canal Irrigation Structure. USACE San Joaquin O&M Manual, Unit 601 Part 1 (SJR601.1), 1967, Revised 25 May 2011, (HLM 34.51), listed as a 3-feet by 3-feet RCBC referenced as the Chowchilla Canal Irrigation Structure]

Slide gate in concrete riser on WS shoulder.

Concrete headwall at LS toe.

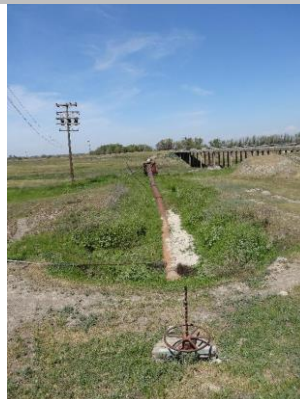
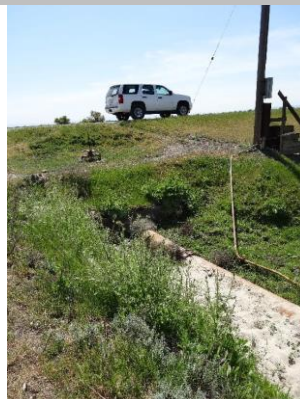
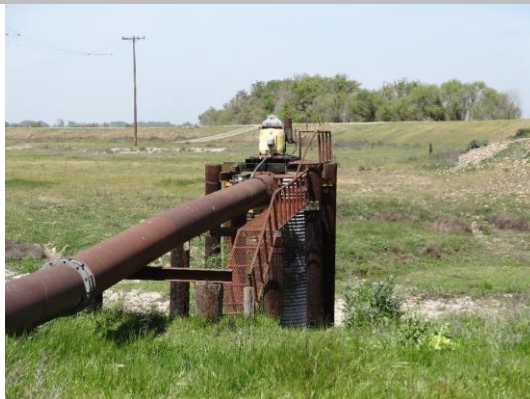
Photo 1 of 3 : UCIP\_SP\_2021\_62229\_66341.jpg

Comment Code						
Inspector Comment						
FS_ID:62229 DS_ID:19815 EP_NO: N/A Repair Type: Non-Urgent Crossing Status: Found UCIP Comments: 04/18/2014 Need to contact owner. Sediment buildup on landward side. Recommend removing sediment buildup on landward toe. (O. Magana - DWR UCIP) FIELD_STRUCT_DESC: 24-inch corrugated metal irrigation discharge pipe through the levee, 7.2 feet below the crown. Pump on concrete structure in the channel. Slide gate in a 36-inch corrugated metal pipe (CMP) riser on the waterside (WS) slope. Concrete headwall on each end. [Additional Reference(s): DWR Levee Log, 2002 (HLM 0.74), listed as a 24-inch corrugated metal pipe (CMP). USACE San Joaquin O&M Manual, Unit 601 Part 1 (SRJ601.1), 1967, Revised 25 May 2011, (HLM 0.74), listed as a 24-inch CMP] FS Date: 4/18/2014

View of waterward side.

View of slope on waterward side.

Pump station visible on waterward side.

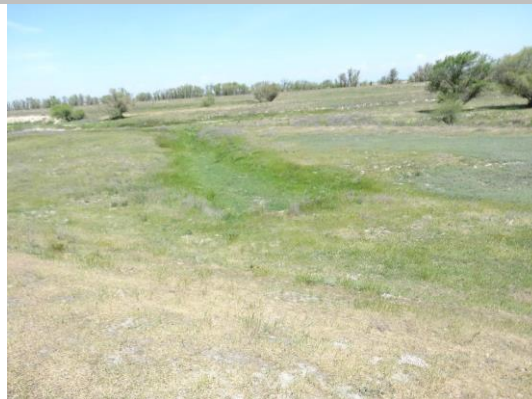
Photo 1 of 3 : UCIP\_SP\_2021\_62230\_66346.jpg

FS\_ID:62230  
DS\_ID:19816  
EP\_NO: N/A  
Repair Type: Non-Urgent  
Crossing Status: Found  
UCIP Comments: 04/18/2014 Landward side blocked--need to contact owner to determine status of crossing. (O. Magana - DWR UCIP)  
FIELD\_STRUCT\_DESC: 24-inch corrugated metal gravity drainage pipe through the levee, 16.2 feet below the crown. Flap gate on the waterside (WS) end. Concrete U-shaped headwall on each end.  
[Additional Reference(s): DWR Levee Log, 2002 (HLM 0.86), listed as a 24-inch corrugated metal pipe (CMP). USACE San Joaquin O&M Manual, Unit 601 Part 1 (SRJ601.1), 1967, Revised 25 May 2011, (HLM 0.86), listed as a 24-inch CMP]  
FS Date: 4/18/2014

Overview of waterward side.

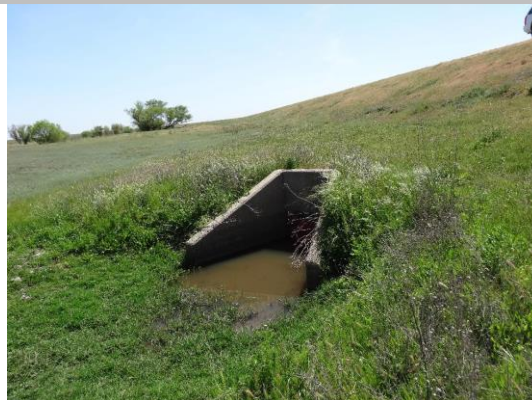
Photo 2 of 3 : UCIP\_SP\_2021\_62230\_66345.jpg

Concrete structure located on waterward toe.

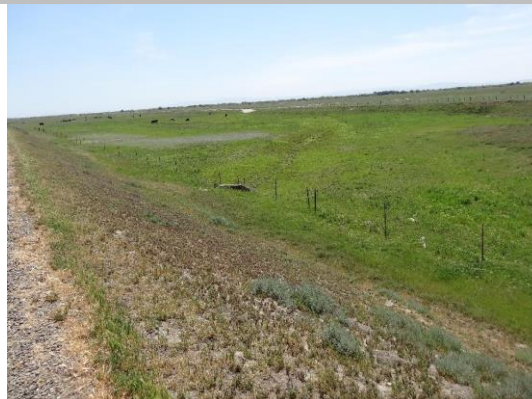
Photo 3 of 3 : UCIP\_SP\_2021\_62230\_66344.jpg

View of landward side.

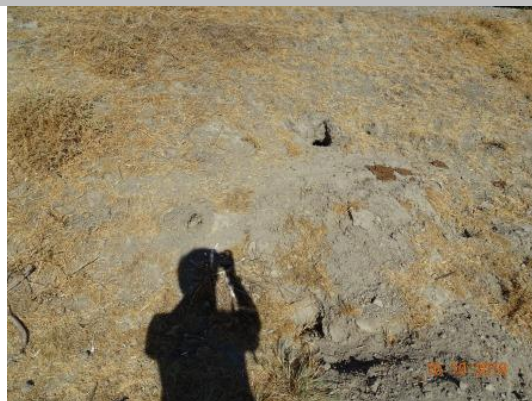
Photo 1 of 1 : SP\_2021\_NA0010\_124\_93\_20210308\_00023.jpg

LM Start	1.18	Rating **	U	Issue No.	93
LM End	1.18	Issue Type +	Ma	Location *	LS
Category	Earthen Levee			GPS Latitude/Longitude	
				Start	End
Item	Animal Control			37.267101 °	37.267101 °
				-120.809603 °	-120.809603 °
DWR ID	DWR_NA0010_06_f_2018_93				
Comment Code					
A3 : No rodents visible, but rodent burrows visible; need to backfill and compact or grout burrows.					
Inspector Comment					
Several rodent burrows including large burrows were observed at this location.

View of landside slope. (Fall 2018)

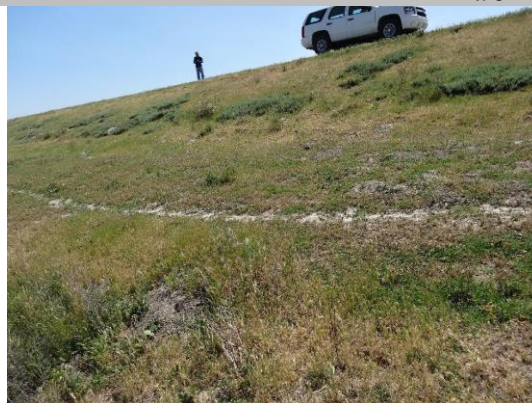
Photo 1 of 3 : UCIP\_SP\_2021\_62231\_66348.jpg

Comment Code						
Inspector Comment						
FS_ID:62231 DS_ID:19817 EP_NO: N/A Repair Type: Non-Urgent Crossing Status: Found UCIP Comments: 04/18/2014 No access was available to landward side due to fence. Recommend removing some of the vegetation on waterward toe. (O. Magana - DWR UCIP) FIELD_STRUCT_DESC: 24-inch corrugated metal gravity drainage pipe through the levee, 13.5 feet below the crown. Flap gate on the waterside (WS) end. Concrete headwall on each end. [Additional Reference(s): DWR Levee Log, 2002 (HLM 1.96), listed as a 24-inch corrugated metal pipe (CMP). USACE San Joaquin O&M Manual, Unit 601 Part 1 (SRJ601.1), 1967, Revised 25 May 2011, (HLM 1.95), listed as a 24-inch CMP] FS Date: 4/18/2014

View of waterward side.

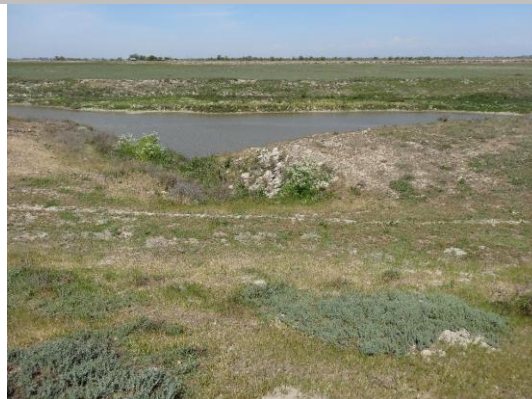
Photo 2 of 3 : UCIP\_SP\_2021\_62231\_66350.jpg

View of waterward side.

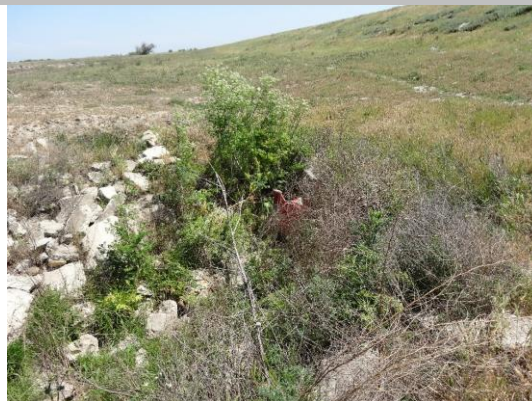
Photo 3 of 3 : UCIP\_SP\_2021\_62231\_66349.jpg

Flap gate visible on waterward side.

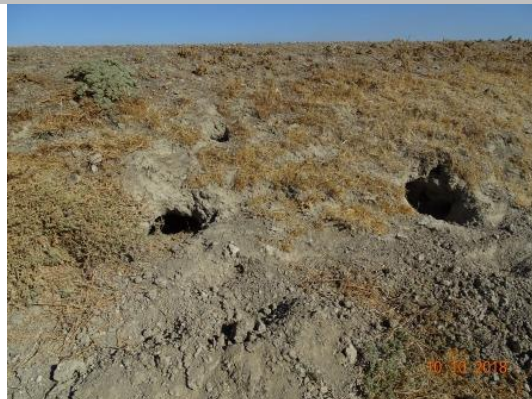
Photo 1 of 1 : SP\_2021\_NA0010\_124\_92\_20210308\_00022.jpg

LM Start	2.42	Rating **	U	Issue No.	92
LM End	2.42	Issue Type +	Ma	Location *	LS
Category	Earthen Levee			GPS Latitude/Longitude	
				Start	End
Item	Animal Control			37.254519 °	37.254519 °
				-120.795141 °	-120.795141 °
DWR ID	DWR_NA0010_06_f_2018_92				
Comment Code					
A3 : No rodents visible, but rodent burrows visible; need to backfill and compact or grout burrows.					
Inspector Comment

View of large rodent holes in landside slope. (Fall 2018)

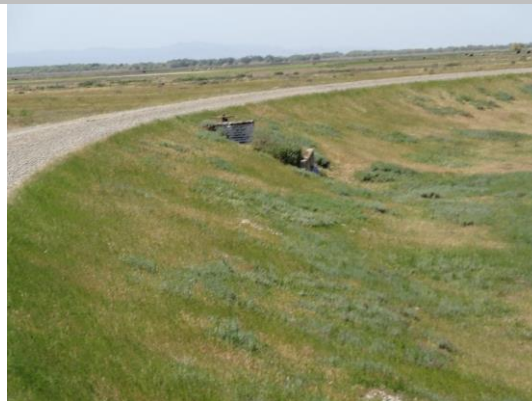
Photo 1 of 3 : UCIP\_SP\_2021\_62242\_66354.jpg

Comment Code						
Inspector Comment						
FS_ID:62242						
DS_ID:19818						
EP_NO: N/A						
Repair Type: Non-Urgent						
Crossing Status: Found						
UCIP Comments: 04/18/2014 Need to contact owner. Sediment						
buildup in pipe visible on landward side. (O. Magana - DWR UCIP)						
FIELD_STRUCT_DESC: 36-inch corrugated metal gravity drainage						
pipe through the levee, 6.9 feet below the crown. Slide gate in a 48-inch						
corrugated metal pipe (CMP) riser on the waterside (WS) slope.						
Concrete headwall on each end. [Additional Reference(s): DWR Levee						
Log, 2002 (HLM 2.61), listed as a 36-inch corrugated metal pipe (CMP).						
USACE San Joaquin O&M Manual, Unit 601 Part 1 (SRJ601.1), 1967,						
Revised 25 May 2011, (HLM 2.61), listed as a 36-inch CMP]						
FS Date: 4/18/2014

View of waterward side.

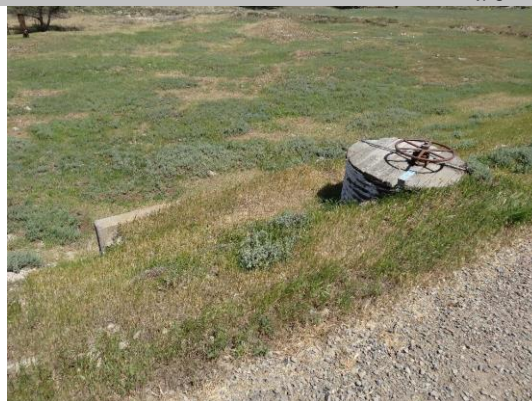
Photo 2 of 3 : UCIP\_SP\_2021\_62242\_66357.jpg

View of waterward side.

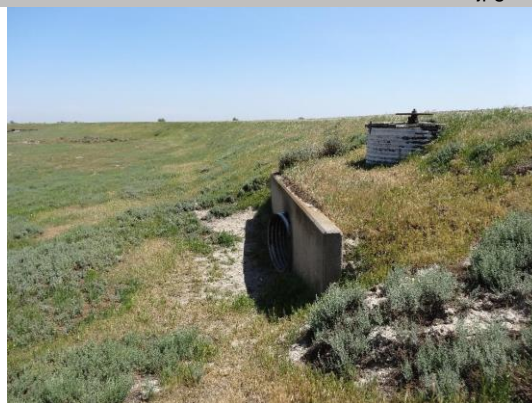
Photo 3 of 3 : UCIP\_SP\_2021\_62242\_66356.jpg

CMP riser, concrete headwall, and pipe visible on waterward side.

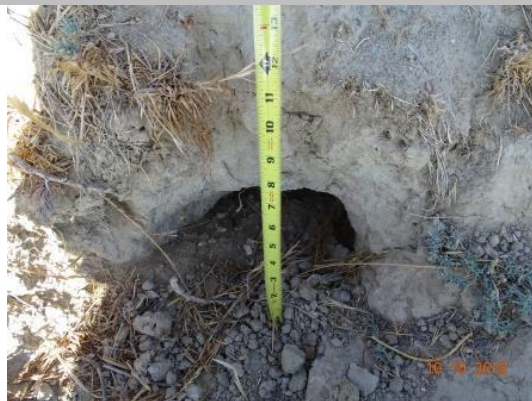
Photo 1 of 1 : SP\_2021\_NA0010\_124\_76\_20210308\_00011.jpg

LM Start	2.54	Rating **	M	Issue No.	76
LM End	2.54	Issue Type +	Ma	Location *	LS
Category	Earthen Levee			GPS Latitude/Longitude	
				Start	End
Item	Animal Control			37.252874 °	37.252874 °
				-120.794192 °	-120.794192 °
DWR ID	DWR_NA0010_06_f _ 2016_76				
Comment Code					
A3 : No rodents visible, but rodent burrows visible; need to backfill and compact or grout burrows.					
Inspector Comment					
There are several rodent burrows in the landside slope at this location.

Representative view of rodent burrow found at this section. (Fall 2018)

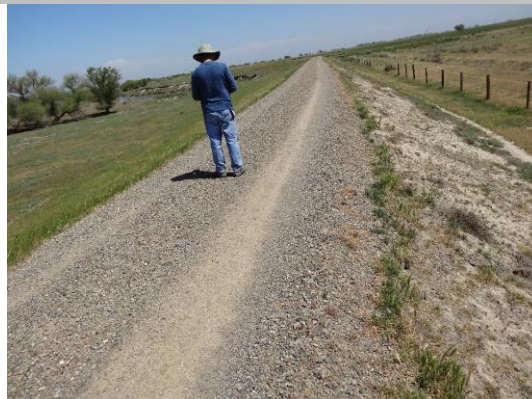
Photo 1 of 3 : UCIP\_SP\_2021\_62233\_66362.jpg

FS\_ID:62233  
DS\_ID:19819  
EP\_NO: N/A  
Repair Type: Non-Urgent  
Crossing Status: Found  
UCIP Comments: 04/18/2014 Dense vegetation limits the inspector's visibility to identify signs of pipe condition on landward toe--headwall blocked by dense vegetation. Recommend removing vegetation from landward toe. (O. Magana - DWR UCIP)  
FIELD\_STRUCT\_DESC: 24-inch corrugated metal gravity drainage pipe through the levee, 9.2 feet below the crown. Flap gate on the waterside (WS) end. Concrete headwall on each end. [Additional Reference(s): DWR Levee Log, 2002 (HLM 2.65), listed as a 24-inch corrugated metal pipe (CMP). USACE San Joaquin O&M Manual, Unit 601 Part 1 (SRJ601.1), 1967, Revised 25 May 2011, (HLM 2.65), listed as a 24-inch CMP]  
FS Date: 4/18/2014

Overview of levee crown at crossing.

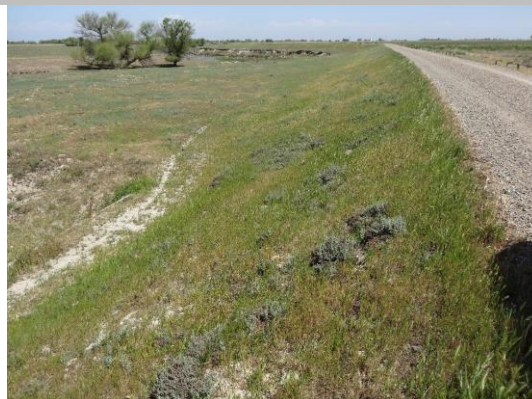
Photo 2 of 3 : UCIP\_SP\_2021\_62233\_66360.jpg

View of waterward side.

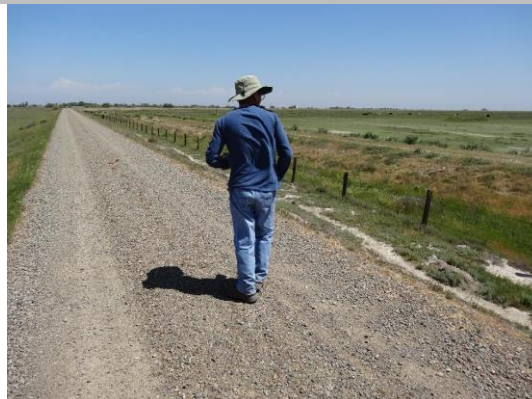
Photo 2 of 3 : UCIP\_SP\_2021\_62234\_66368.jpg

Overview of levee crown at crossing.

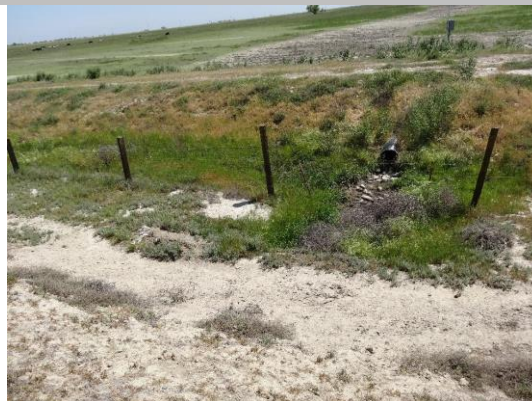
Photo 3 of 3 : UCIP\_SP\_2021\_62234\_66372.jpg

View of landward side.

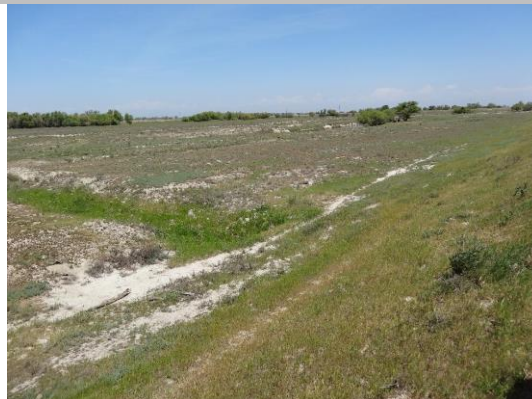
Photo 1 of 3 : UCIP\_SP\_2021\_62236\_66381.jpg

Comment Code						
Inspector Comment						
FS_ID:62236 DS_ID:19821 EP_NO: N/A Repair Type: Non-Urgent Crossing Status: Found UCIP Comments: 04/18/2014 Dense vegetation limits the inspector's visibility to identify signs of pipe condition on landward toe--headwall blocked by dense vegetation. Recommend removing vegetation from landward toe. (O. Magana - DWR UCIP) FIELD_STRUCT_DESC: 24-inch corrugated metal gravity drainage pipe through the levee, 11.2 feet below the crown. Flap gate on the waterside (WS) end. Concrete headwall on each end. [Additional Reference(s): DWR Levee Log, 2002 (HLM 3.09), listed as a 24-inch corrugated metal pipe (CMP). USACE San Joaquin O&M Manual, Unit 601 Part 1 (SRJ601.1), 1967, Revised 25 May 2011, (HLM 3.09), listed as a 24-inch CMP] FS Date: 4/18/2014

View of waterward side.

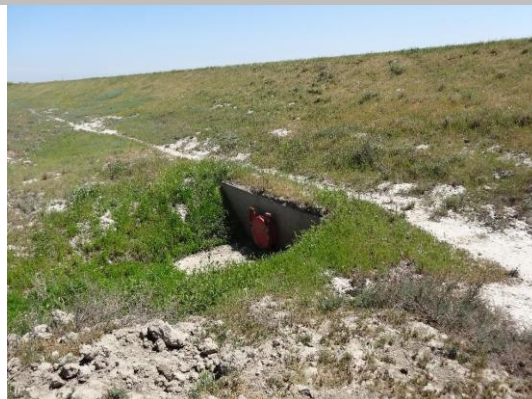
Photo 2 of 3 : UCIP\_SP\_2021\_62236\_66380.jpg

Flap gate and concrete headwall visible on waterward side.

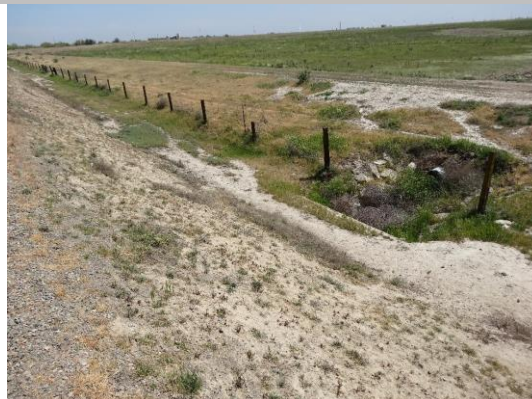
Photo 3 of 3 : UCIP\_SP\_2021\_62236\_66383.jpg

View of landward side.

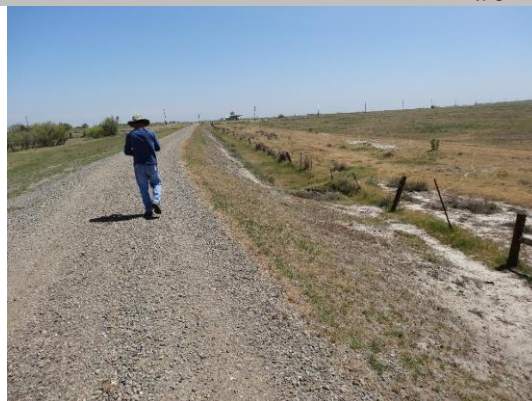
Photo 1 of 3 : UCIP\_SP\_2021\_62237\_66384.jpg

FS\_ID:62237  
DS\_ID:19822  
EP\_NO: N/A  
Repair Type: Non-Urgent  
Crossing Status: Found  
UCIP Comments: 04/18/2014 Dense vegetation limits the inspector's visibility to identify signs of pipe condition on waterward slope and landward toe (headwall blocked by dense vegetation). Recommend removing vegetation from landward toe. (O. Magana - DWR UCIP)  
FIELD\_STRUCT\_DESC: 24-inch corrugated metal gravity drainage pipe through the levee, 10.4 feet below the crown. Flap gate on the waterside (WS) end. Concrete headwall on each end. [Additional Reference(s): DWR Levee Log, 2002 (HLM 3.29), listed as a 24-inch corrugated metal pipe (CMP). USACE San Joaquin O&M Manual, Unit 601 Part 1 (SRJ601.1), 1967, Revised 25 May 2011, (HLM 3.29), listed as a 24-inch CMP]  
FS Date: 4/18/2014

Overview of levee crown and landward side.

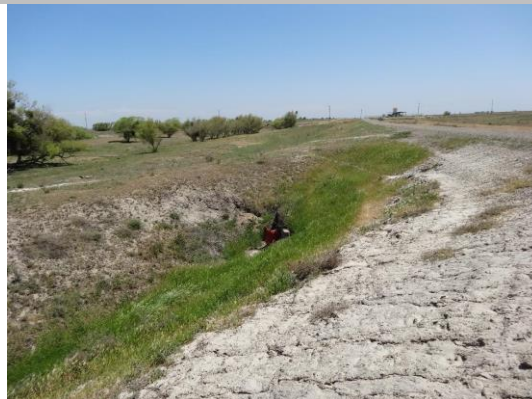
Photo 2 of 3 : UCIP\_SP\_2021\_62237\_66386.jpg

View of waterward side.

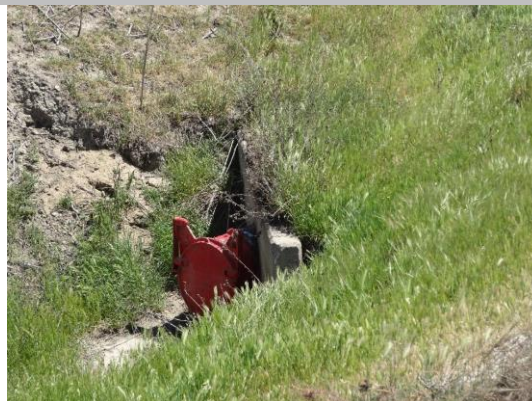
Photo 3 of 3 : UCIP\_SP\_2021\_62237\_66385.jpg

Crossing goes through the levee at an angle. Flap gate visible on waterward side.

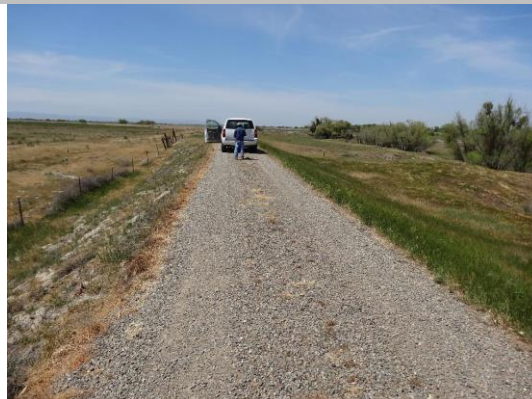
Photo 1 of 3 : UCIP\_SP\_2021\_62243\_66389.jpg

Comment Code						
Inspector Comment						
FS_ID:62243 DS_ID:19823 EP_NO: N/A Repair Type: Non-Urgent Crossing Status: Found UCIP Comments: 04/18/2014 Alignment of crossing unknown--altered crossing. No headwall found on landward side only siphon breaker found a short distance from landward toe. Tall grass observed on waterward slope and some burrow activity also noticed. Need to contact owner to determine alignment of crossing and status of crossing. (O. Magana - DWR UCIP) FIELD_STRUCT_DESC: 36-inch corrugated metal gravity drainage pipe through the levee, 15.7 feet below the crown. Flap gate on the waterside (WS) end. Concrete U-shaped headwall on each end. Bench mark (BM) stamped 9770-152 on top of the WS headwall. [Additional Reference(s): DWR Levee Log, 2002 (HLM 3.44), listed as a 36-inch corrugated metal pipe (CMP). USACE San Joaquin O&M Manual, Unit 601 Part 1 (SRJ601.1), 1967, Revised 25 May 2011, (HLM 3.43), listed as a 36-inch CMP] FS Date: 4/18/2014

Overview of levee crown at crossing.

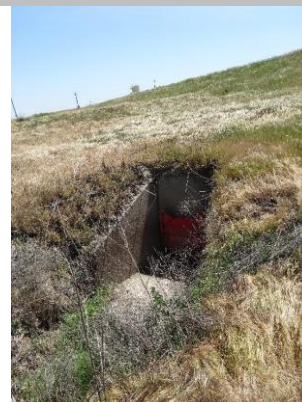
Photo 2 of 3 : UCIP\_SP\_2021\_62243\_66390.jpg

Flap gate and concrete headwall visible on waterward side.

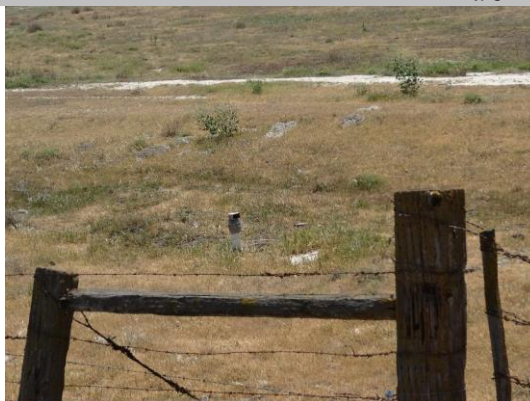
Photo 3 of 3 : UCIP\_SP\_2021\_62243\_66391.jpg

View of landward side. No signs of concrete headwall only siphon breaker visible on landward side.

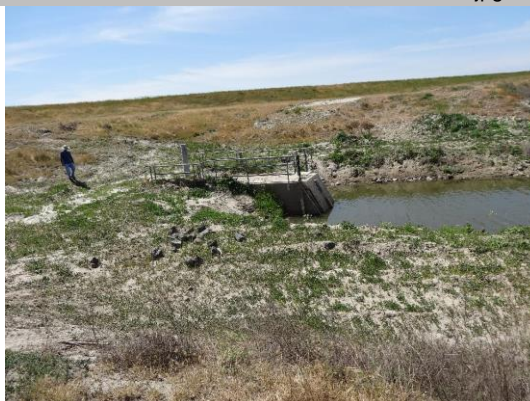
Photo 1 of 3 : UCIP\_SP\_2021\_62240\_71643.jpg

FS\_ID:62240  
DS\_ID:19824  
EP\_NO: 6965  
Repair Type: Non-Urgent  
Crossing Status: Indicator Found  
UCIP Comments: 04/18/2014 Description of structure does not match. Need to contact owner. Current description includes concrete platform, trash screen, and gage reading on waterward side. Metal box located on waterward shoulder. Large plant facility locate on landward side. (O. Magana - DWR UCIP)  
FIELD\_STRUCT\_DESC: 16-inch coated steel irrigation discharge pipe through the levee, 7.4 feet below the crown. Corrugated metal cutoff wall around the pipe in the center of the levee. Pump on the waterside (WS) with a timber platform on the berm for support. Siphon breaker on the apex of the pipe on the landside (LS) shoulder. Pipe exposed on both slopes. (Plans to place a 20-inch irrigation pipe through the levee authorized under Permit No. 6965, 1971 - Scarborough, Robinson, and Associates). [Additional Reference(s): DWR Levee Log, 2002 (HLM 3.44), listed as a 16-inch steel pipe].

View of structure located on waterward side.

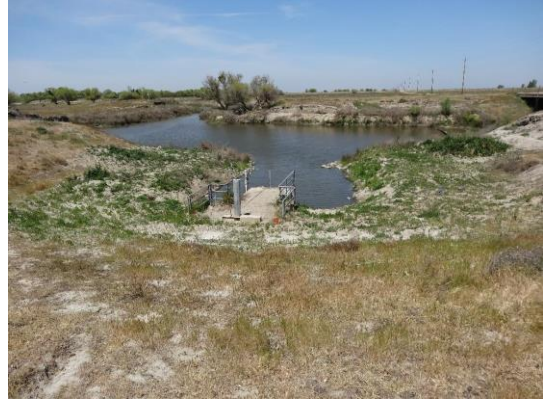
Photo 2 of 3 : UCIP\_SP\_2021\_62240\_71644.jpg

View of waterward side.

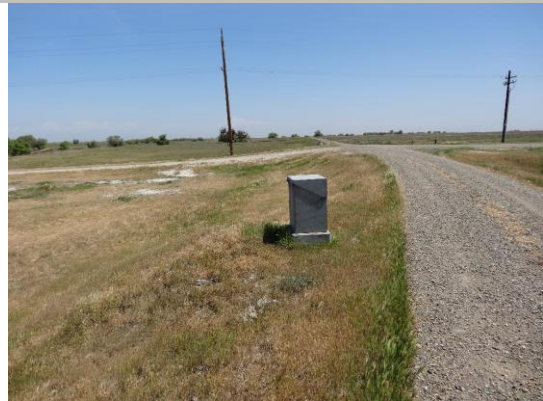
Photo 3 of 3 : UCIP\_SP\_2021\_62240\_71642.jpg

Metal box located on waterward shoulder.

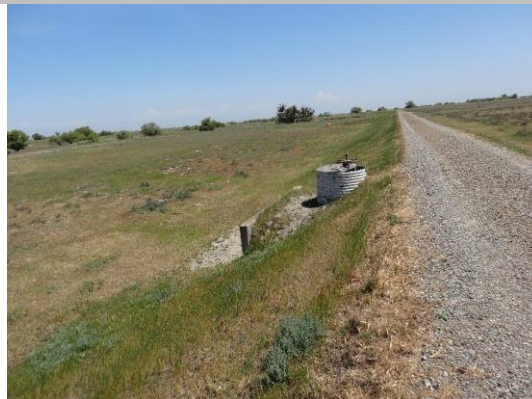
Photo 1 of 3 : UCIP\_SP\_2021\_62241\_66394.jpg

Comment Code					
Inspector Comment					
FS_ID:62241 DS_ID:19825 EP_NO: N/A Repair Type: Non-Urgent Crossing Status: Found UCIP Comments: 04/18/2014 Sediment buildup inside pipe visible from landward side. Excess soil is also present on landward toe partially blocking concrete headwall and inlet. Recommend removing soil from landward toe and clear buildup inside. (O. Magana - DWR UCIP) FIELD_STRUCT_DESC: 36-inch corrugated metal gravity drainage pipe through the levee, 6.8 feet below the crown. Slide gate in a 48-inch corrugated metal pipe (CMP) riser on the waterside (WS) slope. Concrete headwall on each end. Pipe connects to a 30-inch steel drainage pipe on the WS. Drainage pipe extends to the pump on the WS on a support platform in the channel. (Extension drainage pipe and pump installed under Permit No. 12527, 1979 - Joseph Gallo). [Additional Reference(s): DWR Levee Log, 2002 (HLM 3.54), listed as a 36-inch corrugated metal pipe (CMP). USACE San Joaquin O&M Manual, Unit 601 Part 1 (SRJ601.1), 1967, Revised 25 May 2011, (HLM 3.54), listed as a 36-inch CMP] FS Date: 4/18/2014

View of waterward side--cmp riser and concrete headwall visible.

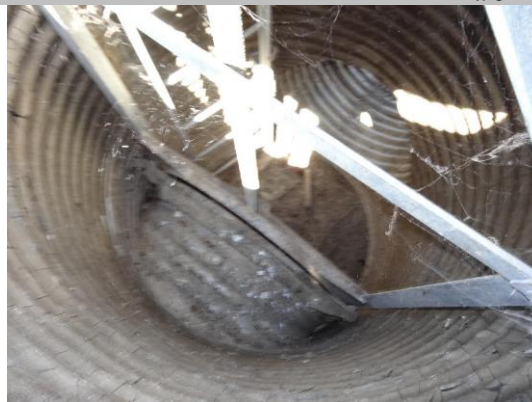
Photo 2 of 3 : UCIP\_SP\_2021\_62241\_66395.jpg

Inside view of cmp riser located on waterward slope.

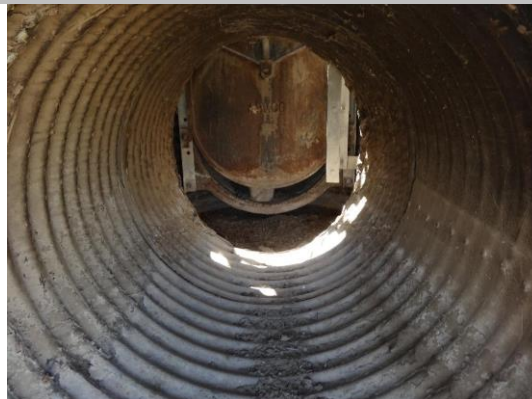
Photo 3 of 3 : UCIP\_SP\_2021\_62241\_66397.jpg

Inside view of pipe from waterward side.

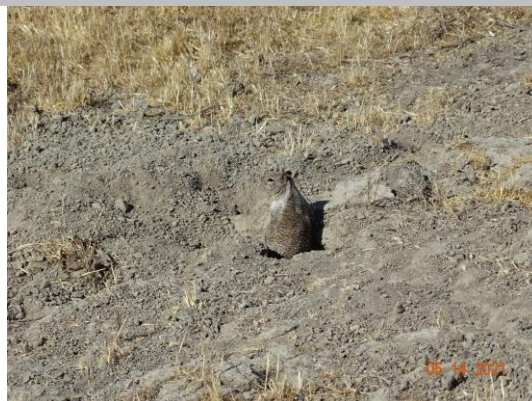
Photo 1 of 1 : SP\_2021\_NA0010\_124\_67\_20210517\_00171.jpg

LM Start	3.49	Rating **	M	Issue No.	67
LM End	3.49	Issue Type +	Ma	Location *	LS
Category	Earthen Levee			GPS Latitude/Longitude	
				Start	End
Item	Animal Control			37.251602 °	37.251602 °
				-120.778118 °	-120.778118 °
DWR ID	DWR_NA0010_06_f _ 2017_67				
Comment Code					
A1 : Exterminate rodents and backfill and compact or grout burrows.					
Inspector Comment

View of active rodent and burrow on the landside slope. (Spring 2021)

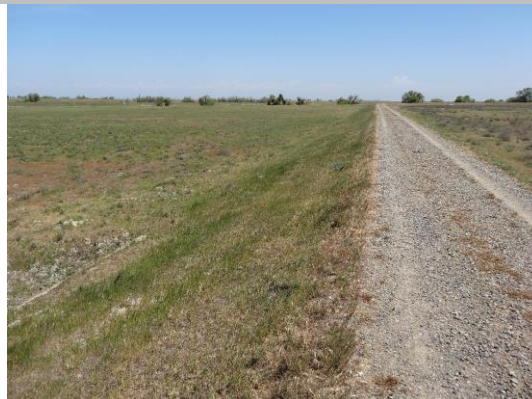
Photo 1 of 3 : UCIP\_SP\_2021\_62244\_66413.jpg

Comment Code						
Inspector Comment						
FS_ID:62244 DS_ID:19826 EP_NO: N/A Repair Type: Non-Urgent Crossing Status: Found UCIP Comments: 04/18/2014 Sediment buildup inside crossing and is visible from landward side. Recommend clearing sediment buildup inside pipe and check wall integrity to determine condition. (O. Magana - DWR UCIP) FIELD_STRUCT_DESC: 24-inch corrugated metal gravity drainage pipe through the levee, 7 feet below the crown. Flap gate on the waterside (WS) end. Concrete headwall on each end. [Additional Reference(s): DWR Levee Log, 2002 (HLM 3.78), listed as a 24-inch corrugated metal pipe (CMP). USACE San Joaquin O&M Manual, Unit 601 Part 1 (SRJ601.1), 1967, Revised 25 May 2011, (HLM 3.77), listed as a 24-inch CMP] FS Date: 4/18/2014

View of waterward side.

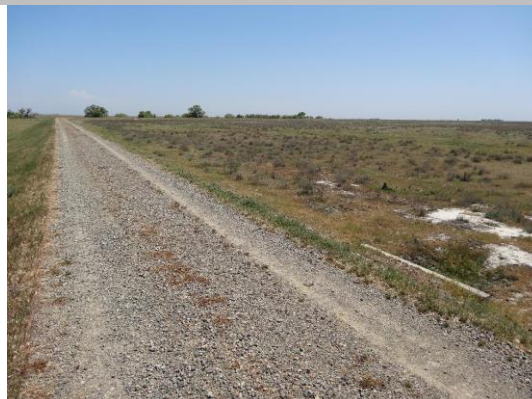
Photo 2 of 3 : UCIP\_SP\_2021\_62244\_66412.jpg

View of landward side.

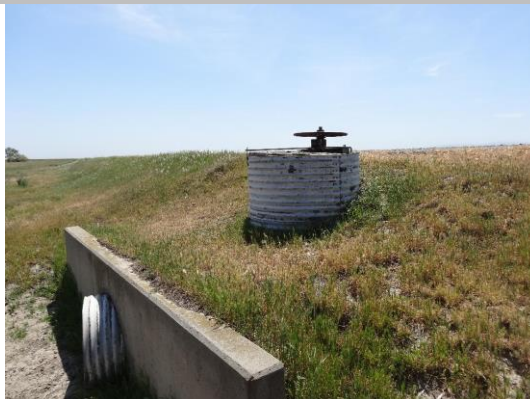
Photo 2 of 3 : UCIP\_SP\_2021\_62245\_66406.jpg

Slide gate inside CMP riser visible on waterward slope.

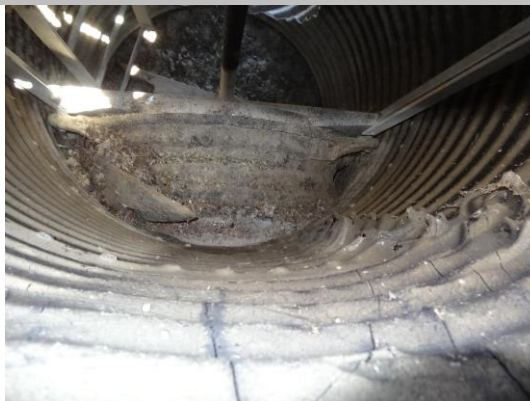
Photo 3 of 3 : UCIP\_SP\_2021\_62245\_66410.jpg

Inside view of CMP riser located on waterward side.

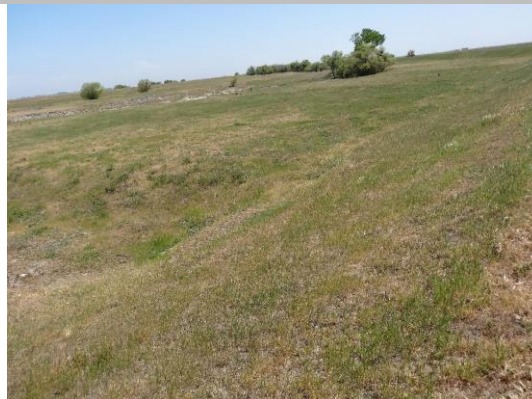
Photo 1 of 3 : UCIP\_SP\_2021\_62246\_66418.jpg

Comment Code						
Inspector Comment						
FS_ID:62246 DS_ID:19828 EP_NO: N/A Repair Type: Non-Urgent Crossing Status: Found UCIP Comments: 04/18/2014 Dense vegetation limits the inspector's visibility to identify signs of pipe condition on landward toe--headwall blocked by dense vegetation. Recommend removing vegetation from landward toe. (O. Magana - DWR UCIP) FIELD_STRUCT_DESC: 24-inch corrugated metal gravity drainage pipe through the levee, 10.8 feet below the crown. Flap gate on the waterside (WS) end. Concrete headwall on each end. [Additional Reference(s): DWR Levee Log, 2002 (HLM 4.17), listed as a 24-inch corrugated metal pipe (CMP). USACE San Joaquin O&M Manual, Unit 601 Part 1 (SRJ601.1), 1967, Revised 25 May 2011, (HLM 4.17), listed as a 24-inch CMP] FS Date: 4/18/2014

View of waterward side.

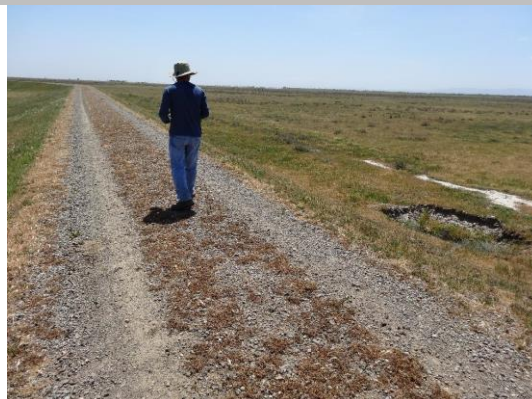
Photo 2 of 3 : UCIP\_SP\_2021\_62246\_66417.jpg

Overview of levee crown at crossing.

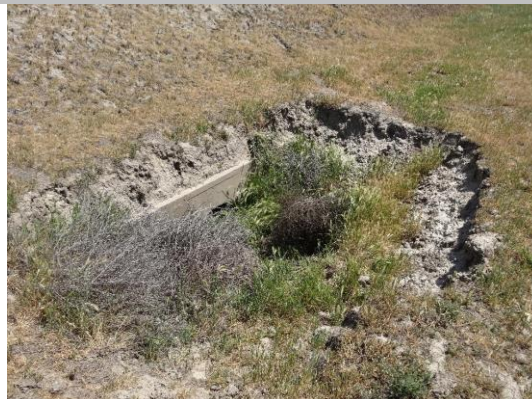
Photo 3 of 3 : UCIP\_SP\_2021\_62246\_66416.jpg

Concrete headwall visible on landward side.

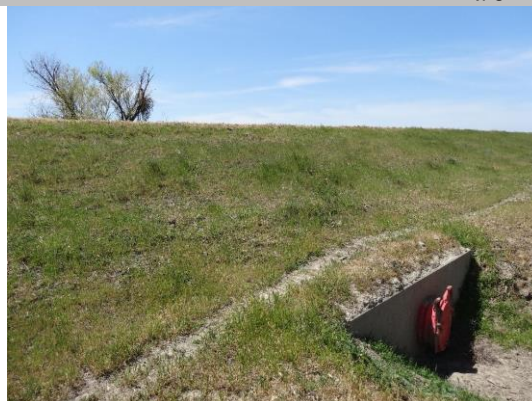
Photo 1 of 2 : UCIP\_SP\_2021\_62247\_66422.jpg

FS\_ID:62247  
DS\_ID:19829  
EP\_NO: N/A  
Repair Type: Non-Urgent  
Crossing Status: Found  
UCIP Comments: 04/18/2014 Dense vegetation limits the inspector's visibility to identify signs of pipe condition on landward toe--headwall blocked by dense vegetation. Recommend removing vegetation from landward toe. (O. Magana - DWR UCIP)  
FIELD\_STRUCT\_DESC: 24-inch corrugated metal gravity drainage pipe through the levee, 11.3 feet below the crown. Flap gate on the waterside (WS) end. Concrete headwall on each end. [Additional Reference(s): DWR Levee Log, 2002 (HLM 4.43), listed as a 24-inch corrugated metal pipe (CMP). USACE San Joaquin O&M Manual, Unit 601 Part 1 (SRJ601.1), 1967, Revised 25 May 2011, (HLM 4.41), listed as a 24-inch CMP]  
FS Date: 4/18/2014

View of waterward side--concrete headwall and flap gate visible.

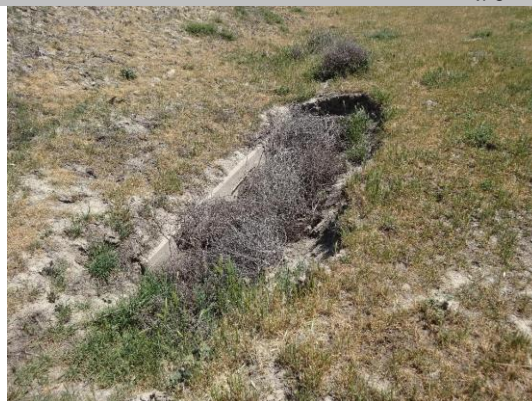
Photo 2 of 2 : UCIP\_SP\_2021\_62247\_66421.jpg

View of landward side--concrete headwall visible through dense vegetation.

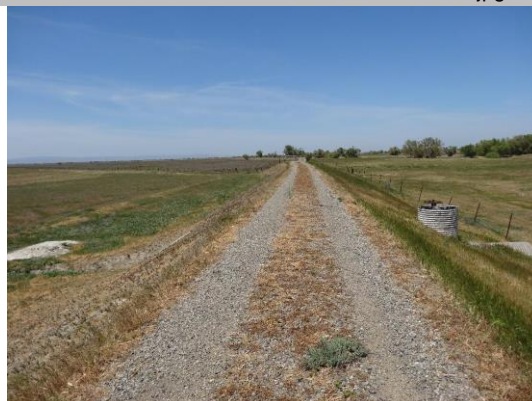
Photo 1 of 3 : UCIP\_SP\_2021\_62248\_66425.jpg

FS\_ID:62248  
DS\_ID:19830  
EP\_NO: N/A  
Repair Type: Non-Urgent  
Crossing Status: Found  
UCIP Comments: 04/18/2014 Sediment buildup inside crossing visible from landward side. Recommend clearing sediment buildup inside pipe and check wall integrity to determine condition. (O. Magana - DWR UCIP)  
FIELD\_STRUCT\_DESC: 36-inch corrugated metal gravity drainage pipe through the levee, 6.9 feet below the crown. Slide gate in a 48-inch corrugated metal pipe (CMP) riser on the waterside (WS) slope. Concrete headwall on the landside (LS) end. Concrete saddle and apron on the WS end. [Additional Reference(s): DWR Levee Log, 2002 (HLM 4.69), listed as a 36-inch corrugated metal pipe (CMP). USACE San Joaquin O&M Manual, Unit 601 Part 1 (SRJ601.1), 1967, Revised 25 May 2011, (HLM 4.70), listed as a 36-inch CMP]  
FS Date: 4/18/2014

Overview of levee crown at crossing.

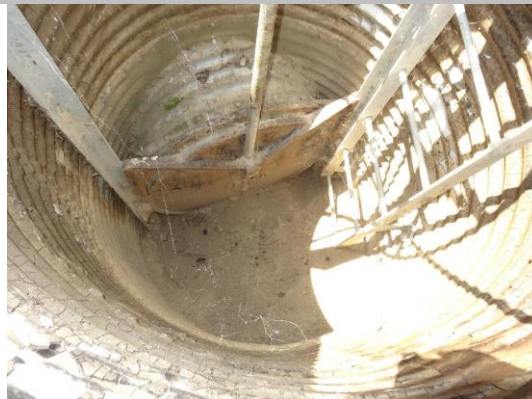
Photo 2 of 3 : UCIP\_SP\_2021\_62248\_66426.jpg

Inside view of CMP riser located on waterward.

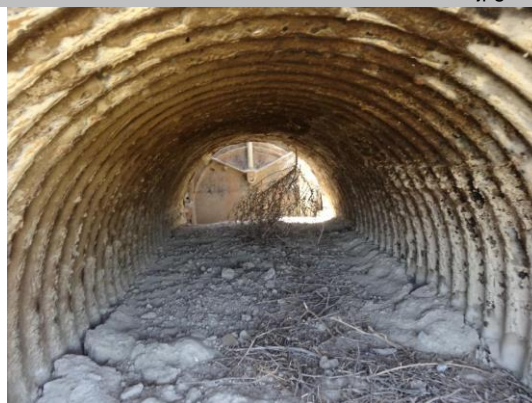
Photo 3 of 3 : UCIP\_SP\_2021\_62248\_66424.jpg

Inside view of pipe from waterward side.

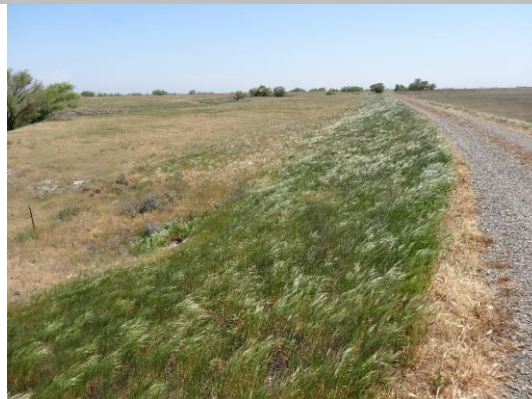
Photo 1 of 3 : UCIP\_SP\_2021\_62249\_66433.jpg

Comment Code						
Inspector Comment						
FS_ID:62249 DS_ID:19831 EP_NO: N/A Repair Type: Non-Urgent Crossing Status: Found UCIP Comments: 04/18/2014 Need to contact owner. Recommend removing tall grass on landward toe to determine condition of crossing from landward side. (O. Magana - DWR UCIP) FIELD_STRUCT_DESC: 24-inch corrugated metal gravity drainage pipe through the levee, 11.8 feet below the crown. Flap gate on the waterside (WS) end. Concrete headwall on each end. [Additional Reference(s): DWR Levee Log, 2002 (HLM 4.75), listed as a 24-inch corrugated metal pipe (CMP). USACE San Joaquin O&M Manual, Unit 601 Part 1 (SRJ601.1), 1967, Revised 25 May 2011, (HLM 4.75), listed as a 24-inch CMP] FS Date: 4/18/2014

View of waterward side.

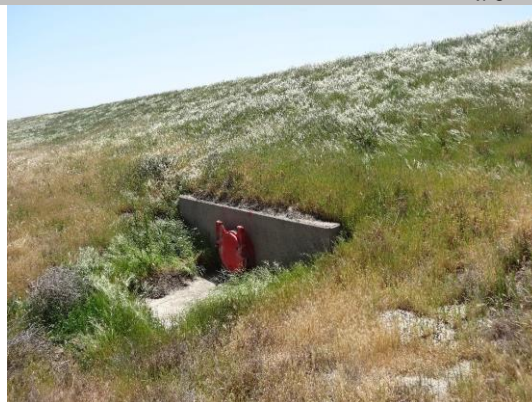
Photo 2 of 3 : UCIP\_SP\_2021\_62249\_66432.jpg

Flap gate, concrete headwall and apron visible on waterward toe.

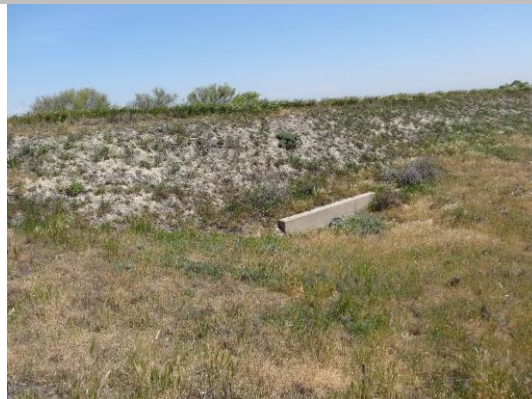
Photo 3 of 3 : UCIP\_SP\_2021\_62249\_66431.jpg

View of landward side.

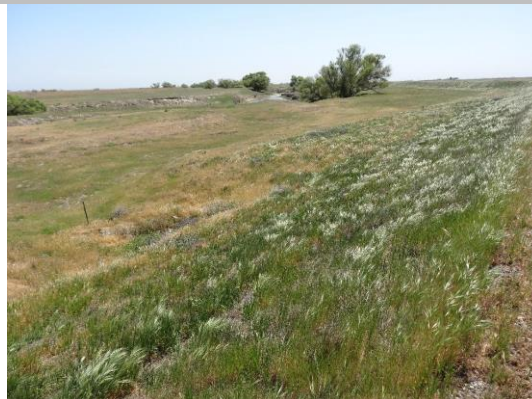
Photo 1 of 3 : UCIP\_SP\_2021\_62250\_66436.jpg

FS\_ID:62250  
DS\_ID:19862  
EP\_NO: N/A  
Repair Type: Non-Urgent  
Crossing Status: Found  
UCIP Comments: 04/18/2014 Dense vegetation limits the inspector's visibility to identify signs of pipe failure (leaks) along the waterward slope. Recommend removing vegetation along waterward slope to conduct proper inspection of structure. Also recommend removing dense vegetation blocking landward headwall. (O. Magana - DWR UCIP)  
FIELD\_STRUCT\_DESC: 24-inch corrugated metal gravity drainage pipe through the levee, 10.8 feet below the crown. Flap gate on the waterside (WS) end. Concrete headwall on each end. [Additional Reference(s): DWR Levee Log, 2002 (HLM 4.95), listed as a 24-inch corrugated metal pipe (CMP). USACE San Joaquin O&M Manual, Unit 601 Part 1 (SRJ601.1), 1967, Revised 25 May 2011, (HLM 4.94), listed as a 24-inch CMP]  
FS Date: 4/18/2014

View of waterward side.

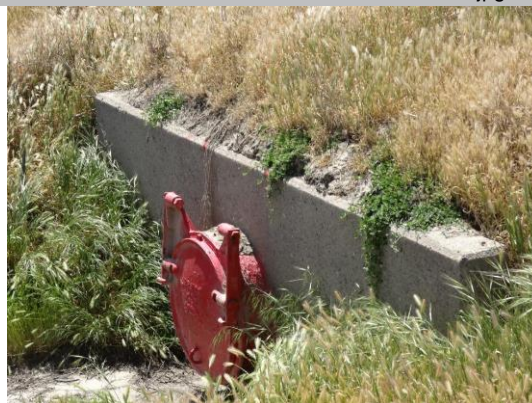
Photo 3 of 3 : UCIP\_SP\_2021\_62250\_66437.jpg

Close up of flap gate located on waterward side.

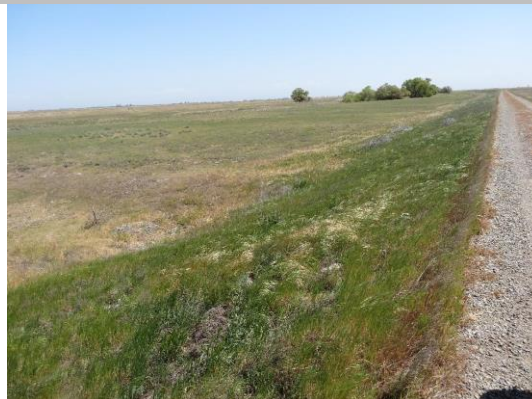
Photo 1 of 3 : UCIP\_SP\_2021\_62251\_61599.jpg

Comment Code						
Inspector Comment						
FS_ID:62251 DS_ID:19863 EP_NO: N/A Repair Type: Non-Urgent Crossing Status: Found UCIP Comments: 04/18/2014 Clear vegetation from waterward slope and landward headwall. (O. Magana - DWR UCIP) FIELD_STRUCT_DESC: 24-inch corrugated metal gravity drainage pipe through the levee, 10.9 feet below the crown. Flap gate on the waterside (WS) end. Concrete headwall on each end. [Additional Reference(s): DWR Levee Log, 2002 (HLM 5.35), listed as a 24-inch corrugated metal pipe (CMP). USACE San Joaquin O&M Manual, Unit 601 Part 1 (SRJ601.1), 1967, Revised 25 May 2011, (HLM 5.34), listed as a 24-inch CMP] FS Date: 4/18/2014

View of waterward side.

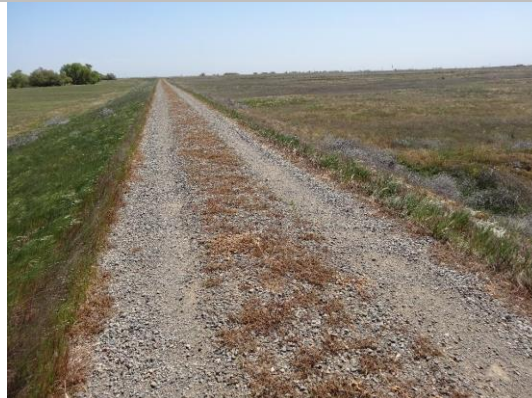
Photo 2 of 3 : UCIP\_SP\_2021\_62251\_61598.jpg

Overview of levee crown at crossing.

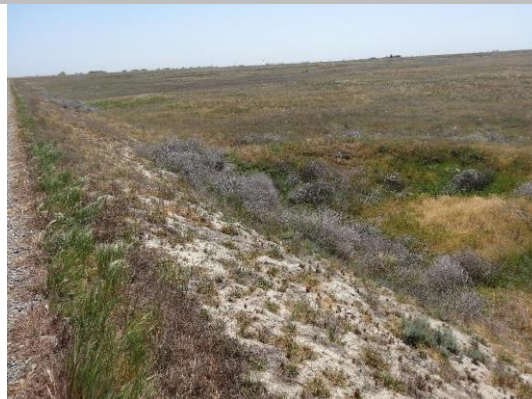
Photo 3 of 3 : UCIP\_SP\_2021\_62251\_61597.jpg

View of landward side.

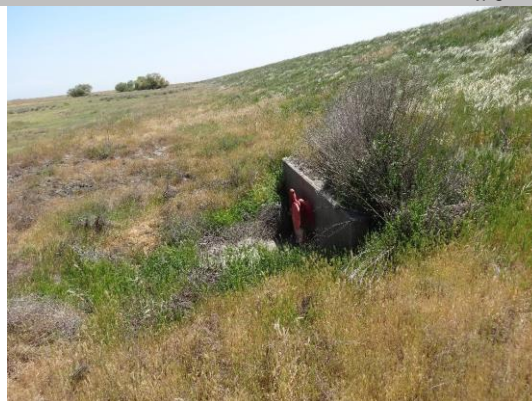
Photo 1 of 3 : UCIP\_SP\_2021\_62252\_66441.jpg

FS\_ID:62252  
DS\_ID:19864  
EP\_NO: N/A  
Repair Type: Non-Urgent  
Crossing Status: Found  
UCIP Comments: 04/18/2014 Dense vegetation limits the inspector's visibility to identify signs of pipe failure (leaks) along the waterward slope. Recommend removing vegetation along pipe alignment to conduct proper inspection of structure. Also recommend removing excess vegetation at landward headwall. (O. Magana - DWR UCIP)  
FIELD\_STRUCT\_DESC: 24-inch corrugated metal gravity drainage pipe through the levee, 11 feet below the crown. Flap gate on the waterside (WS) end. Concrete headwall on each end. [Additional Reference(s): DWR Levee Log, 2002 (HLM 5.63), listed as a 24-inch corrugated metal pipe (CMP). USACE San Joaquin O&M Manual, Unit 601 Part 1 (SRJ601.1), 1967, Revised 25 May 2011, (HLM 5.63), listed as a 24-inch CMP]  
FS Date: 4/18/2014

Concrete headwall and flap gate visible on waterward toe.

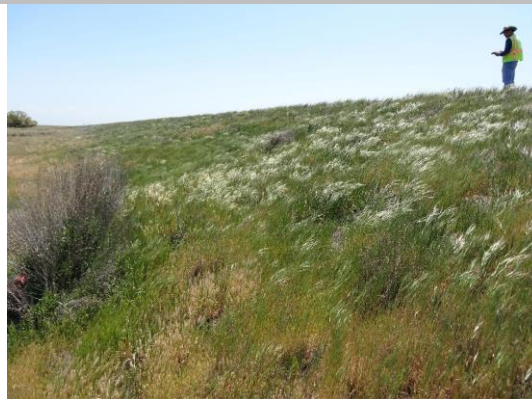
Photo 2 of 3 : UCIP\_SP\_2021\_62252\_66440.jpg

View of waterward side--dense vegetation covers slope.

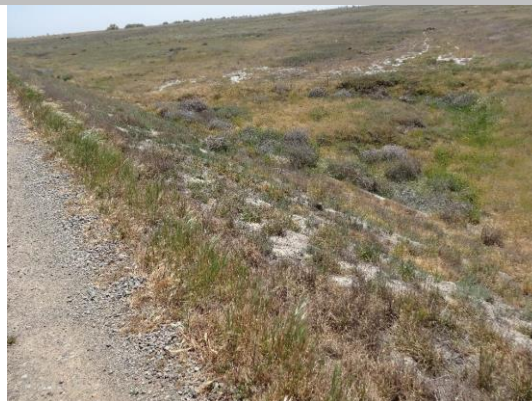
Photo 3 of 3 : UCIP\_SP\_2021\_62252\_66439.jpg

View of landward side.

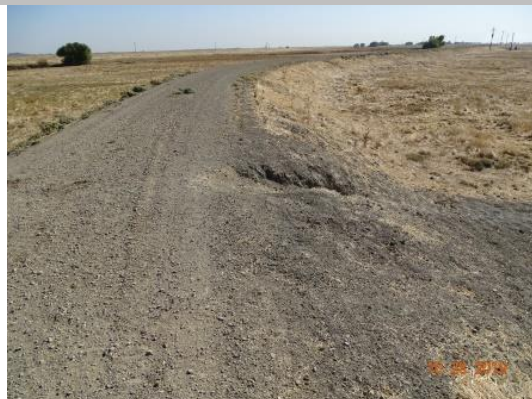
Photo 1 of 1 : SP\_2021\_NA0010\_124\_66\_20210308\_00006.jpg

LM Start	5.77	Rating **	M	Issue No.	66
LM End	5.77	Issue Type +	Ma	Location *	LS
Category	Earthen Levee			GPS Latitude/Longitude	
				Start	End
Item	Animal Control			37.238354 °	37.238354 °
				-120.742480 °	-120.742480 °
DWR ID	DWR_NA0010_06_f _ 2017_66				
Comment Code					
A2 : Repair the levee slope damaged by livestock and prevent large animal access.					
Inspector Comment					
There is damage to the landside slope and shoulder from livestock.

View of damage to landside slope from livestock traffic looking downstream. (Fall 2019)

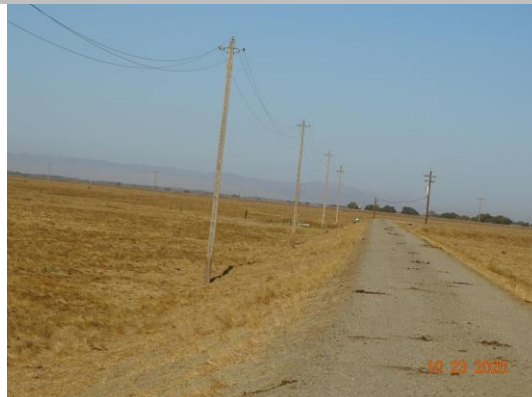
Photo 1 of 1 : SP\_2021\_NA0010\_124\_69\_20210308\_00009.jpg

LM Start	5.93	Rating **	M	Issue No.	69
LM End	7.09	Issue Type +	En	Location *	LS
Category	Earthen Levee			GPS Latitude/Longitude	
				Start	End
Item	Encroachments			37.236936 °	37.226800 °
				-120.740384 °	-120.724736 °
DWR ID	DWR_NA0010_06_f_2015_69				
Comment Code					
PO : Pole					
Inspector Comment					
There are several PG&E poles within this section at the landside toe and slope.

Looking downstream at PG&amp;E poles on the landside slope and toe. (Fall 2020)
