# Flood Control Project Maintenance Levee Inspections LMA District Cover Sheet

## Lower San Joaquin Levee District

**Flood Control Project Maintenance  
Levee Inspections  
Unit Cover Sheet**

Waterway			Bank	Unit Miles
Unit No. 01 San Joaquin River			Right	22.52
	Spring (March - May)	Summer (June - August)	(September - November) Fall	Winter (December - February)
Unit Maintenance Rating (Fall Only)				
Date of Inspection	5/4/2021 - 5/4/2021			
DWR Inspector	Corey Fujitani			
Accompanied By

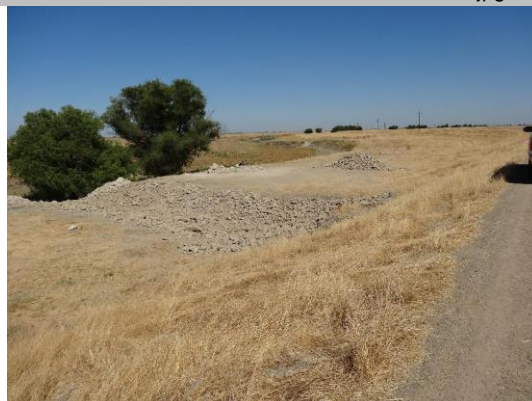
Photo 1 of 3 : UCIP\_SP\_2021\_62253\_75493.jpg

Comment Code					
Inspector Comment					
FS_ID:62253					
DS_ID:19865					
EP_NO: N/A					
Repair Type: No Action Needed					
Crossing Status: Found					
UCIP Comments: 7/19/2016 Site has been repaired on WS and LS (see photos below). (O. Magana - DWR UCIP)5/26/2016 Erosion is undermining the WS headwall of drainage structure (photos of WS headwall provided by DWR Inspector R. Willoughby). Potential pipe failure at the outlet just behind headwall, recommend completing internal wall integrity of pipe length through levee to determine extent of damage to pipe. (O. Magana - DWR UCIP)4/18/2014 Need to contact owner. Sediment buildup in pipe visible on landside-- recommend clearing. (O. Magana - DWR UCIP)					
FIELD_STRUCT_DESC: 24-inch corrugated metal gravity drainage pipe through the levee, 9 feet below the crown. Flap gate on the waterside (WS) end. Concrete headwall on each end. [Additional Reference(s): DWR Levee Log, 2002 (HLM 6.06), listed as a 24-inch corrugated metal pipe (CMP). USACE San Joaquin O&M Manual, Unit 601 Part 1 (SRJ601.1), 1967, Revised 25 May 2011, (HLM 6.06), listed as a 24-inch CMP]

View of WS--rock protection along drainage path.

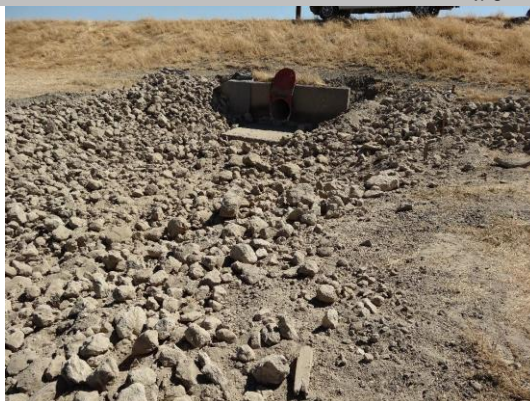
Photo 2 of 3 : UCIP\_SP\_2021\_62253\_75488.jpg

WS drainage path protected by rip rap.

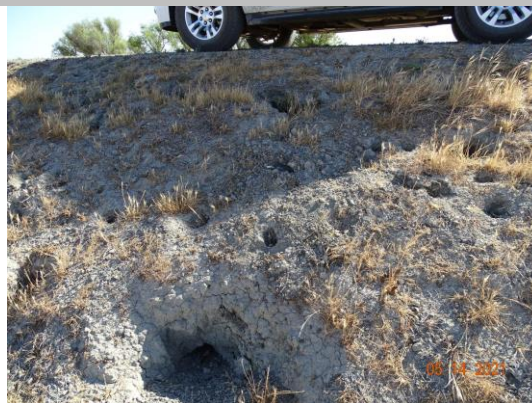
Photo 1 of 1 : SP\_2021\_NA0010\_124\_90\_20210517\_00172.jpg

LM Start	6.63	Rating **	M	Issue No.	90
LM End	6.63	Issue Type +	Ma	Location *	LS
Category	Earthen Levee			GPS Latitude/Longitude	
				Start	End
Item	Animal Control			37.231384 °	37.231384 °
				-120.730297 °	-120.730297 °
DWR ID	DWR_NA0010_06_s_2021_90				
Comment Code					
A3 : No rodents visible, but rodent burrows visible; need to backfill and compact or grout burrows.					
Inspector Comment

Looking at multiple rodent holes in the landside slope. (Spring 2021)

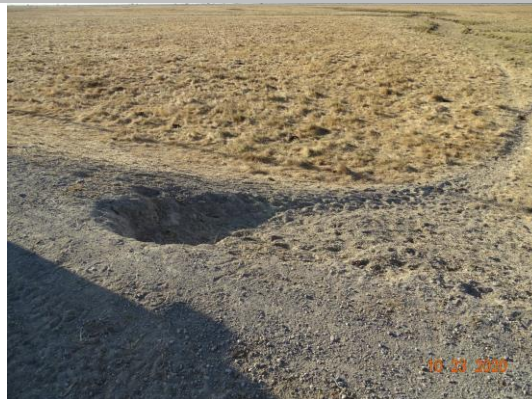
Photo 1 of 1 : SP\_2021\_NA0010\_124\_79\_20210308\_00013.jpg

LM Start	6.92	Rating **	A/W	Issue No.	79
LM End	6.92	Issue Type +	Ma	Location *	LS
Category	Earthen Levee			GPS Latitude/Longitude	
				Start	End
Item	Animal Control			37.228054 °	37.228054 °
				-120.727428 °	-120.727428 °
DWR ID	DWR_NA0010_06_f _ 2018_79				
Comment Code					
A2 : Repair the levee slope damaged by livestock and prevent large animal access.					
Inspector Comment					
Slope damage has been repaired with loose soil. Monitor for settlement.

View down the landside slope of damage from livestock. (Fall 2020)

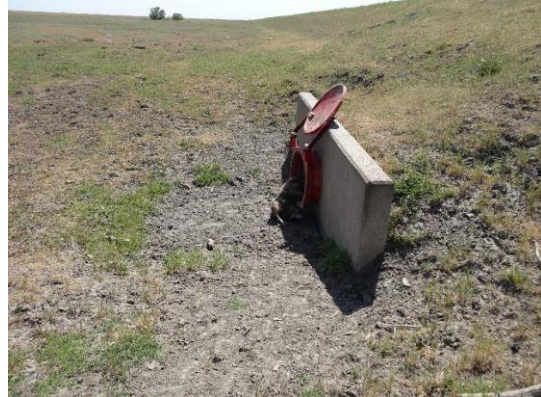
Photo 2 of 3 : UCIP\_SP\_2021\_62256\_61649.jpg

Comment Code					
Inspector Comment					
FS_ID:62256					
DS_ID:19868					
EP_NO: N/A					
Repair Type: Non-Urgent					
Crossing Status: Found					
UCIP Comments: 04/18/2014 Need to contact owner. Clear animal from waterward side. Some sediment buildup in pipe visible landward side--recommend clearing. (O. Magana - DWR UCIP)					
FIELD_STRUCT_DESC: 24-inch corrugated metal gravity drainage pipe through the levee, 10.6 feet below the crown. Flap gate on the waterside (WS) end. Concrete headwall on each end. [Additional Reference(s): DWR Levee Log, 2002 (HLM 7.29), listed as a 24-inch corrugated metal pipe (CMP). USACE San Joaquin O&M Manual, Unit 601 Part 1 (SRJ601.1), 1967, Revised 25 May 2011, (HLM 7.29), listed as a 24-inch CMP]					
FS Date: 4/18/2014

Concrete headwall and flap gate visible on waterward side. Dead animal inside pipe.

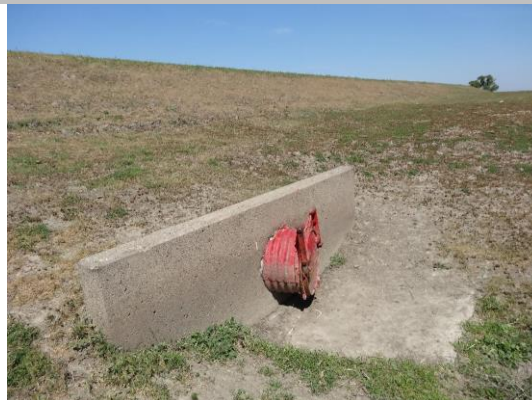
Photo 2 of 3 : UCIP\_SP\_2021\_62257\_66461.jpg

Comment Code						
Inspector Comment						
FS_ID:62257						
DS_ID:19869						
EP_NO: N/A						
Repair Type: Non-Urgent						
Crossing Status: Found						
UCIP Comments: 04/18/2014 Some sediment buildup in pipe visible on						
landward side--recommend clearing. (O. Magana - DWR UCIP)						
FIELD_STRUCT_DESC: 24-inch corrugated metal gravity drainage						
pipe through the levee, 11.8 feet below the crown. Flap gate on the						
waterside (WS) end. Concrete headwall on each end. Skewed crossing.						
[Additional Reference(s): DWR Levee Log, 2002 (HLM 7.74), listed as a						
24-inch corrugated metal pipe (CMP). USACE San Joaquin O&M						
Manual, Unit 601 Part 1 (SRJ601.1), 1967, Revised 25 May 2011, (HLM

Pipe crosses levee at an angle.

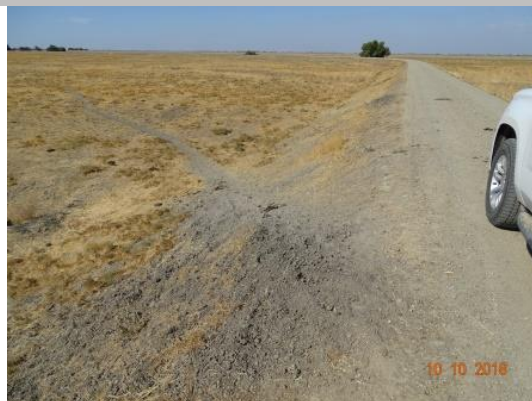
Photo 1 of 1 : SP\_2021\_NA0010\_124\_74\_20210308\_00010.jpg

LM Start	7.66	Rating **	A/W	Issue No.	74
LM End	7.66	Issue Type +	Ma	Location *	LS
Category	Earthen Levee			GPS Latitude/Longitude	
				Start	End
Item	Animal Control			37.222689 °	37.222689 °
				-120.716400 °	-120.716400 °
DWR ID	DWR_NA0010_06_f _ 2018_74				
Comment Code					
A2 : Repair the levee slope damaged by livestock and prevent large animal access.					
Inspector Comment					
Damage to levee slope from livestock access.

Slope damage from livestock. (Fall 2018)

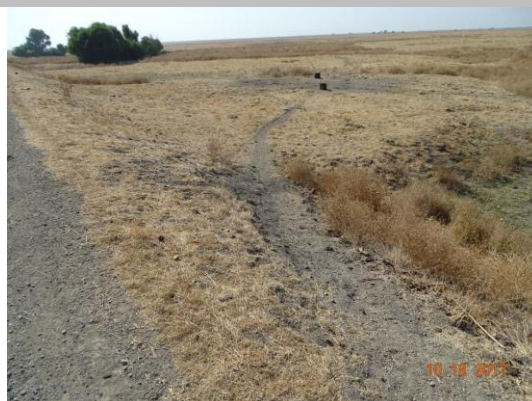
Photo 1 of 1 : SP\_2021\_NA0010\_124\_65\_20210308\_00005.jpg

LM Start	8.08	Rating **	A/W	Issue No.	65
LM End	8.08	Issue Type +	Ma	Location *	LS
Category	Earthen Levee			GPS Latitude/Longitude	
				Start	End
Item	Animal Control			37.217199 °	37.217199 °
				-120.713374 °	-120.713374 °
DWR ID	DWR_NA0010_06_f_2017_65				
Comment Code					
A2 : Repair the levee slope damaged by livestock and prevent large animal access.					
Inspector Comment					
Livestock damage to levee slope.

Looking southwest at the landside slope.

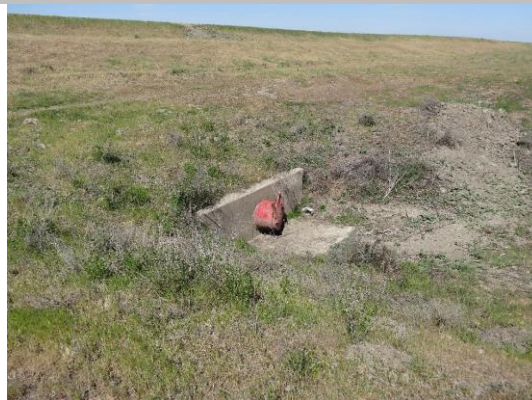
Photo 2 of 3 : UCIP\_SP\_2021\_62259\_61673.jpg

Comment Code						
Inspector Comment						
FS_ID:62259 DS_ID:19870 EP_NO: N/A Repair Type: Non-Urgent Crossing Status: Found UCIP Comments: 04/18/2014 Sediment buildup in pipe--recommend contacting owner to clear sediment. (O. Magana - DWR UCIP) FIELD_STRUCT_DESC: 24-inch corrugated metal gravity drainage pipe through the levee, 16.5 feet below the crown. Flap gate on the waterside (WS) end. Concrete headwall on each end. [Additional Reference(s): DWR Levee Log, 2002 (HLM 8.22), listed as a 24-inch corrugated metal pipe (CMP). USACE San Joaquin O&M Manual, Unit 601 Part 1 (SRJ601.1), 1967, Revised 25 May 2011, (HLM 8.21), listed as a 24-inch CMP] FS Date: 4/18/2014

Pipe crosses levee at an angle.

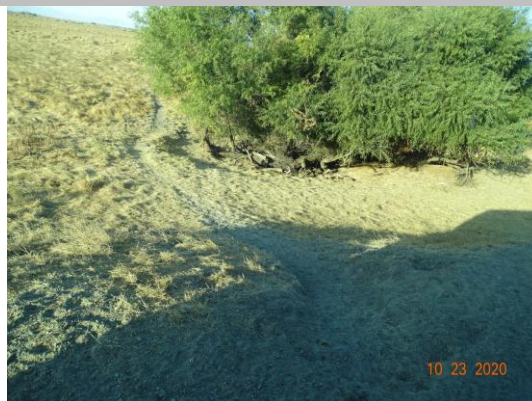
Photo 1 of 1 : SP\_2021\_NA0010\_124\_104\_20210308\_00029.jpg

LM Start	8.20	Rating **	A/W	Issue No.	104
LM End	8.20	Issue Type +	Ma	Location *	LS
Category	Earthen Levee			GPS Latitude/Longitude	
				Start	End
Item	Animal Control			37.215588 °	37.215588 °
				-120.712406 °	-120.712406 °
DWR ID	DWR_NA0010_06_f_2020_104				
Comment Code					
A2 : Repair the levee slope damaged by livestock and prevent large animal access.					
Inspector Comment					
Slope damage has been repaired with loose soil. Monitor for settlement.

Livestock damage to the landside slope. (Fall 2020)

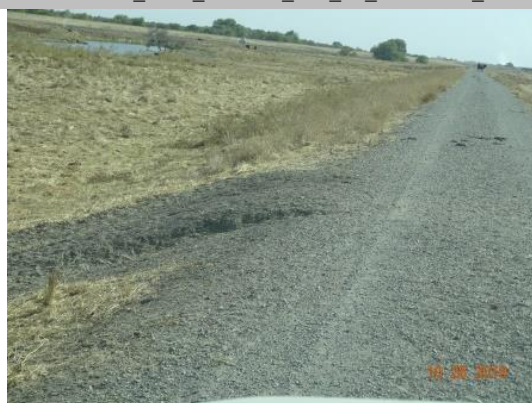
Photo 1 of 1 : SP\_2021\_NA0010\_124\_89\_20210308\_00020.jpg

LM Start	8.32	Rating **	A/W	Issue No.	89
LM End	8.32	Issue Type +	Ma	Location *	WS
Category	Earthen Levee			GPS Latitude/Longitude	
				Start	End
Item	Animal Control			37.214273 °	37.214273 °
				-120.711100 °	-120.711100 °
DWR ID	DWR_NA0010_06_f_2019_89				
Comment Code					
A2 : Repair the levee slope damaged by livestock and prevent large animal access.					
Inspector Comment					
Slope damage has been repaired with loose soil. Monitor for settlement.

View of damage to the waterside slope looking upstream. (Fall 2019)

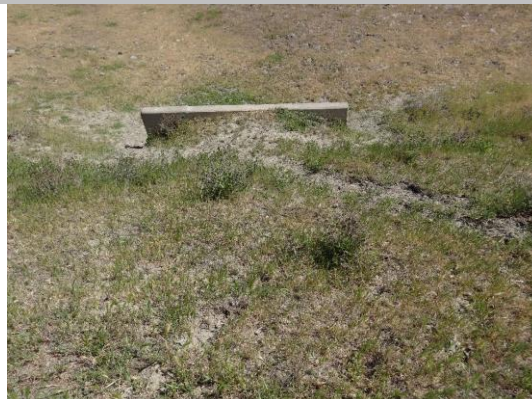
Photo 1 of 3 : UCIP\_SP\_2021\_62260\_61685.jpg

FS\_ID:62260  
DS\_ID:19871  
EP\_NO: N/A  
Repair Type: Non-Urgent  
Crossing Status: Found  
UCIP Comments: 04/18/2014 Need to contact owner. Sediment buildup in pipe visible on landward side--recommend clearing. Good candidate for pressure test or video inspection due to signs of heavy corrosion. If no leaks after tests this crossing would be a good candidate for rehabilitation. (O. Magana - DWR UCIP)  
FIELD\_STRUCT\_DESC: 24-inch corrugated metal gravity drainage pipe through the levee, 9.2 feet below the crown. Flap gate on the waterside (WS) end. Concrete headwall on each end. [Additional Reference(s): DWR Levee Log, 2002 (HLM 8.51), listed as a 24-inch corrugated metal pipe (CMP). USACE San Joaquin O&M Manual, Unit 601 Part 1 (SRJ601.1), 1967, Revised 25 May 2011, (HLM 8.51), listed as a 24-inch CMP]  
FS Date: 4/18/2014

View of waterward side.

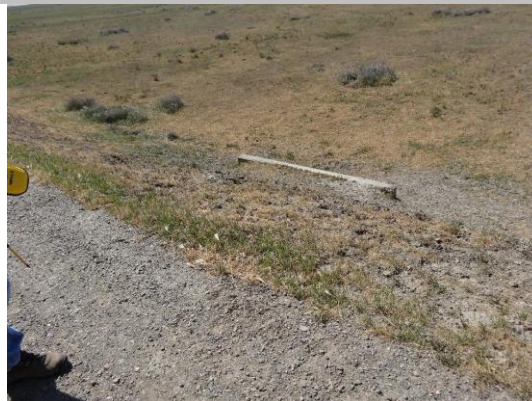
Photo 2 of 3 : UCIP\_SP\_2021\_62260\_61684.jpg

View of landward side.

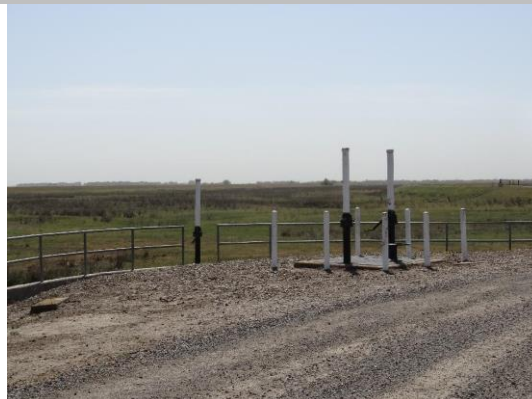
Photo 2 of 3 : UCIP\_SP\_2021\_62262\_72921.jpg

Concrete box located on waterward side.

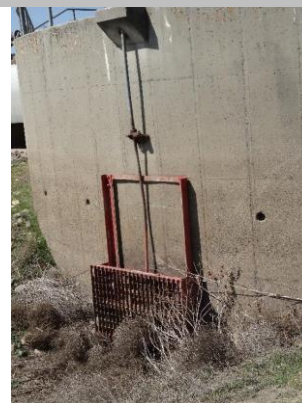
Photo 3 of 3 : UCIP\_SP\_2021\_62262\_72920.jpg

Trash gate visible on waterward side.

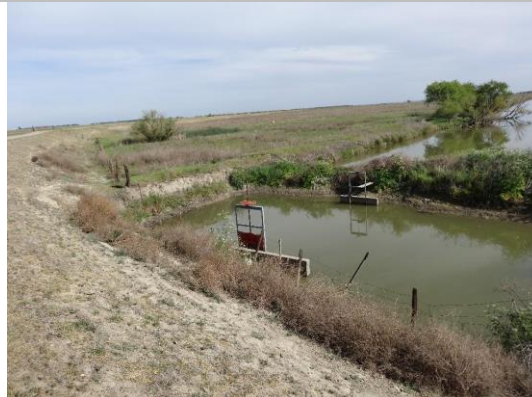
Photo 1 of 2 : UCIP\_SP\_2021\_62266\_61691.jpg

LM Start	9.66	Rating **	M	Issue No.	42
LM End	9.66	Issue Type +	En	Location *	
Category	Supplemental			GPS Latitude/Longitude	
				Start	End
Item	DWR UCIP Field Study			37.200948 °	37.200948 °
				-120.694362 °	-120.694362 °
DWR ID	19874				
Comment Code					
Inspector Comment					
FS_ID:62266 DS_ID:19874 EP_NO: N/A Repair Type: Non-Urgent Crossing Status: Found UCIP Comments: 04/17/2014 Waterward side not visible--need to determine alignment. (O. Magana - DWR UCIP) FIELD_STRUCT_DESC: 36-inch corrugated metal gravity drainage pipe through the levee, 14 feet below the crown. Slide gate in a concrete diversion box on the waterside (WS) shoulder. [Additional Reference(s): DWR Levee Log, 2002 (HLM 9.76), listed as a 36-inch corrugated metal pipe (CMP)]. FS Date: 4/17/2014

View of landward side.

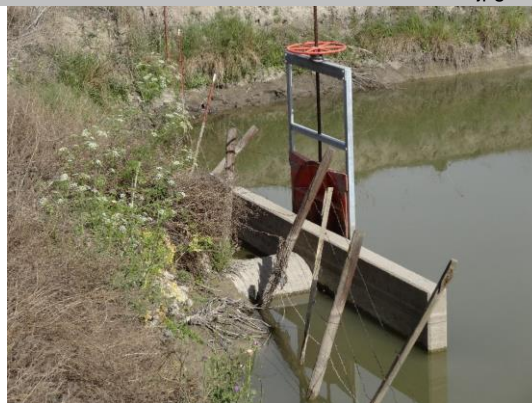
Photo 2 of 2 : UCIP\_SP\_2021\_62266\_61690.jpg

Pipe, slide gate, and concrete headwall visible on landward side.

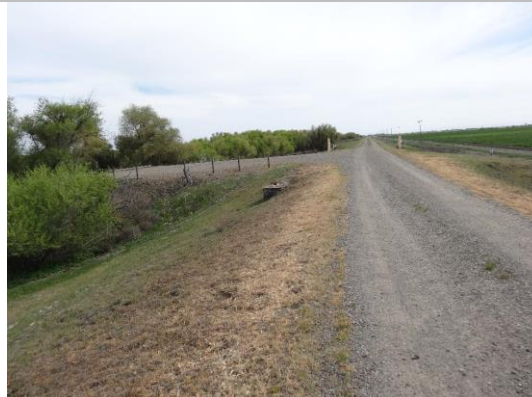
Photo 1 of 3 : UCIP\_SP\_2021\_62268\_66488.jpg

LM Start	11.74	Rating **	M	Issue No.	44
LM End	11.74	Issue Type +	Ma	Location *	
Category	Supplemental			GPS Latitude/Longitude	
				Start	End
Item	DWR UCIP LMA Responsibility			37.185513 °	37.185513 °
				-120.664561 °	-120.664561 °
DWR ID	19876				
Comment Code					
Inspector Comment					
FS_ID:62268 DS_ID:19876 EP_NO: N/A Repair Type: Non-Urgent Crossing Status: Found UCIP Comments: 04/17/2014 Clear debris from waterward and landward toes. (O. Magana - DWR UCIP) FIELD_STRUCT_DESC: 36-inch corrugated metal gravity drainage pipe through the levee, 17 feet below the crown. Slide gate in a pipe riser on the waterside (WS) slope. [Additional Reference(s): DWR Levee Log, 2002 (HLM 11.83), listed as a 36-inch corrugated metal pipe (CMP). USACE San Joaquin O&M Manual, Unit 601 Part 1 (SJR601.1), 1967, Revised 25 May 2011, (HLM 11.82), listed as a 36-inch CMP]. FS Date: 4/17/2014

View of waterward side.

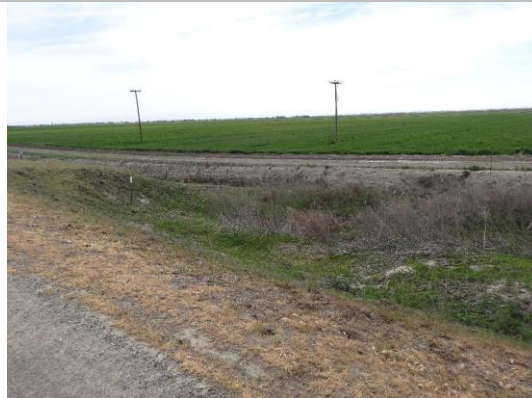
Photo 2 of 3 : UCIP\_SP\_2021\_62268\_66487.jpg

View of landward side.

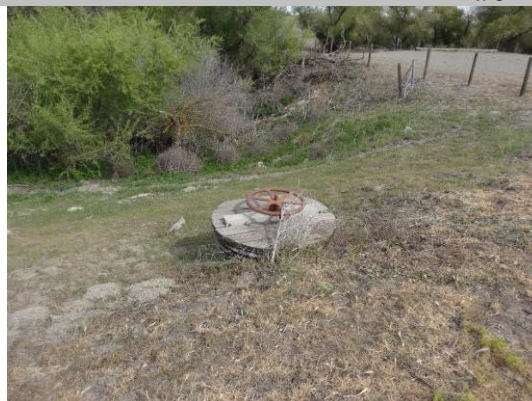
Photo 3 of 3 : UCIP\_SP\_2021\_62268\_66486.jpg

Slide gate inside CMP riser located on waterward slope.

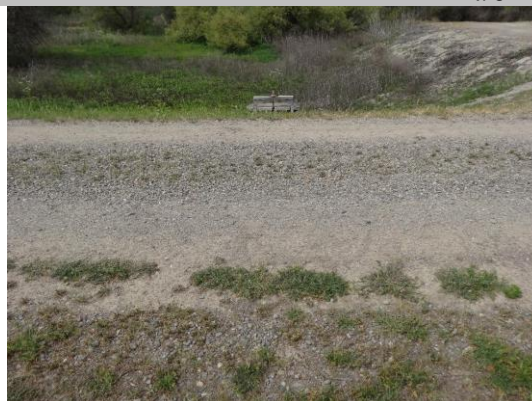
Photo 1 of 3 : UCIP\_SP\_2021\_62270\_66492.jpg

Comment Code						
Inspector Comment						
FS_ID:62270 DS_ID:19877 EP_NO: N/A Repair Type: Non-Urgent Crossing Status: Found UCIP Comments: 04/17/2014 Not accessible--crossing is buried on landward side. Need to contact owner to determine status. (O. Magana - DWR UCIP) FIELD_STRUCT_DESC: 24-inch corrugated metal gravity drainage pipe through the levee, 10.8 feet below the crown. Flap gate on the waterside (WS) end. [Additional Reference(s): DWR Levee Log, 2002 (HLM 18.91), listed as a 24-inch corrugated metal pipe (CMP). USACE San Joaquin O&M Manual, Unit 601 Part 1 (SJR601.1), 1967, Revised 25 May 2011, (HLM 13.30), listed as a 24-inch CMP]. FS Date: 4/17/2014

View of levee crown at crossing.

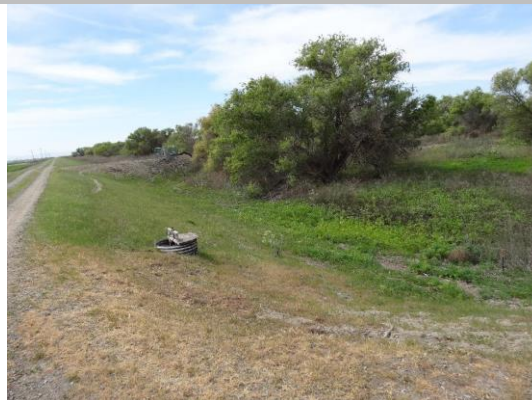
Photo 2 of 3 : UCIP\_SP\_2021\_62270\_66494.jpg

View of waterward slope.

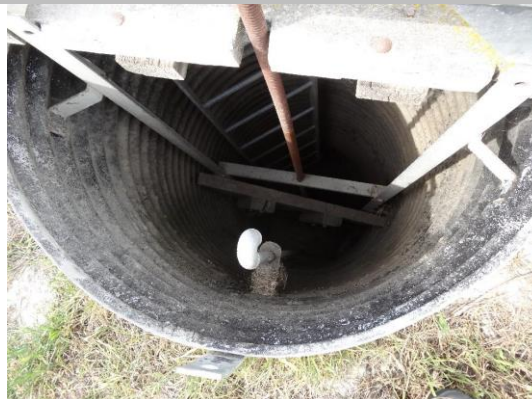
Photo 3 of 3 : UCIP\_SP\_2021\_62270\_66495.jpg

Inside view of CMP riser located on waterward slope.

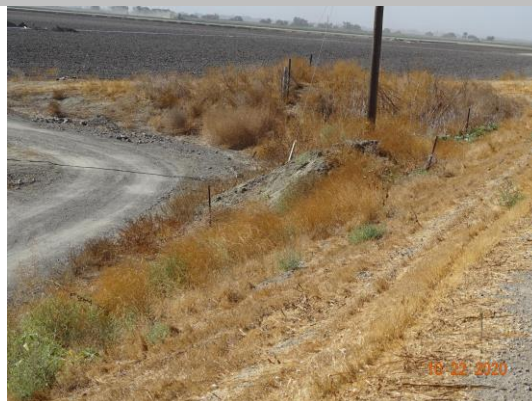
Photo 1 of 1 : SP\_2021\_NA0010\_124\_68\_20210308\_00008.jpg

LM Start	13.24	Rating **	M	Issue No.	68
LM End	13.24	Issue Type +	En	Location *	LS
Category	Earthen Levee			GPS Latitude/Longitude	
				Start	End
Item	Encroachments			37.171686 °	37.171686 °
				-120.654562 °	-120.654562 °
DWR ID	DWR_NA0010_06_f _ 2015_68				
Comment Code					
MA : Material					
Inspector Comment					
Landowner stockpiled dirt at landside toe.

Looking downstream at dirt stockpile on the landside toe. (Fall 2020)

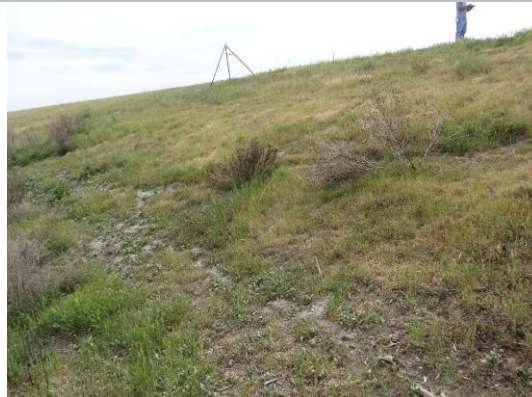
Photo 1 of 3 : UCIP\_SP\_2021\_62271\_66496.jpg

Comment Code					
Inspector Comment					
FS_ID:62271 DS_ID:19878 EP_NO: N/A Repair Type: Non-Urgent Crossing Status: Found UCIP Comments: 04/17/2014 Not accessible--crossing is buried on landward side. Need to contact owner to determine status. (O. Magana - DWR UCIP) FIELD_STRUCT_DESC: 24-inch corrugated metal gravity drainage pipe through the levee, 12.3 feet below the crown. Flap gate on the waterside (WS) end. [Additional Reference(s): DWR Levee Log, 2002 (HLM 14.45), listed as a 24-inch corrugated metal pipe (CMP). USACE San Joaquin O&M Manual, Unit 601 Part 1 (SJR601.1), 1967, Revised 25 May 2011, (HLM 14.44), listed as a 24-inch CMP] FS Date: 4/17/2014

View of waterward slope.

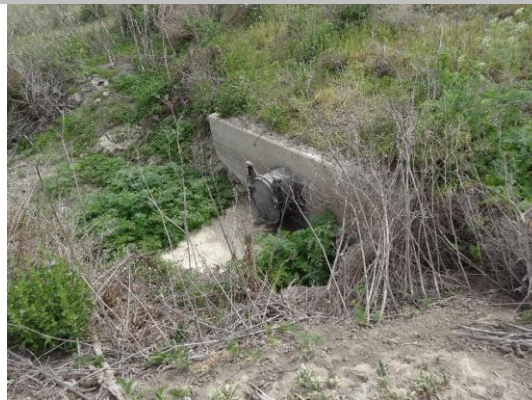
Photo 2 of 3 : UCIP\_SP\_2021\_62271\_66497.jpg

View of pipe daylight, flap gate, and concrete headwall visible on waterward toe.

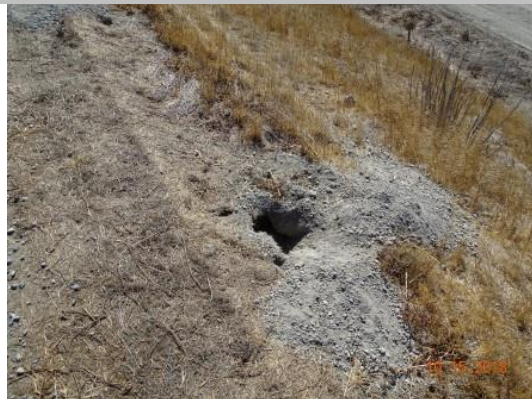
Photo 1 of 1 : SP\_2021\_NA0010\_124\_101\_20210308\_00026.jpg

LM Start	14.63	Rating **	M	Issue No.	101
LM End	14.64	Issue Type +	Ma	Location *	LS
Category	Earthen Levee			GPS Latitude/Longitude	
				Start	End
Item	Animal Control			37.164871 °	37.164824 °
				-120.633222 °	-120.633167 °
DWR ID	DWR_NA0010_06_f _ 2018_101				
Comment Code					
A3 : No rodents visible, but rodent burrows visible; need to backfill and compact or grout burrows.					
Inspector Comment					
Burrows are located along landside shoulder.

View of rodent hole on landside shoulder. (Fall 2018)

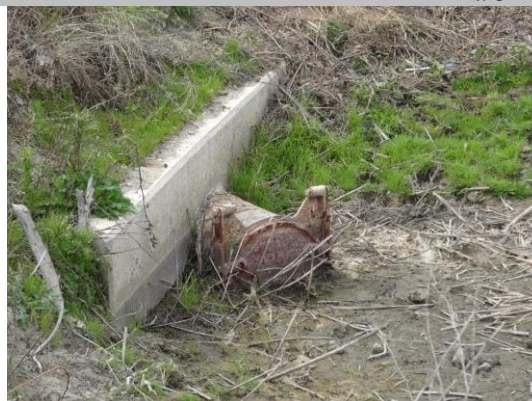
Photo 1 of 3 : UCIP\_SP\_2021\_62272\_66507.jpg

Comment Code					
Inspector Comment					
FS_ID:62272					
DS_ID:19884					
EP_NO: N/A					
Repair Type: Non-Urgent					
Crossing Status: Found					
UCIP Comments: 04/17/2014 Need to contact owner. Sediment buildup on both the waterward and landward side. Recommend removing sediment buildup from both side. Also recommend clearing excess sediment inside crossing. (O. Magana - DWR UCIP)					
FIELD_STRUCT_DESC: 24-inch corrugated metal gravity drainage pipe through the levee, 14 feet below the crown. Flap gate on the waterside (WS) end. [Additional Reference(s): DWR Levee Log, 2002 (HLM 15.78), listed as a 24-inch corrugated metal pipe (CMP). USACE San Joaquin O&M Manual, Unit 601 Part 1 (SJR601.1), 1967, Revised 25 May 2011, (HLM 15.76), listed as a 24-inch CMP].					
FS Date: 4/17/2014

Flap gate buried halfway on waterward side.

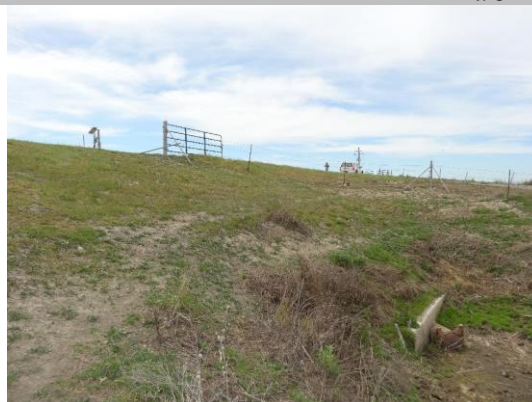
Photo 2 of 3 : UCIP\_SP\_2021\_62272\_66506.jpg

View of waterward side.

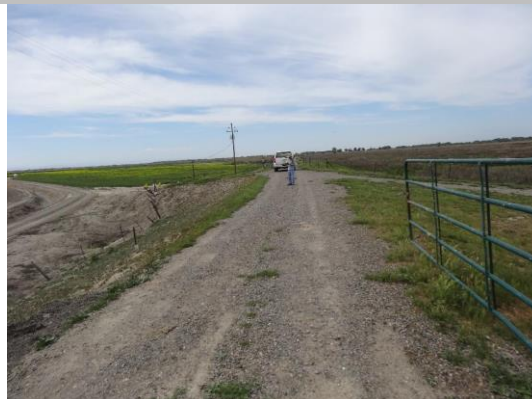
Photo 3 of 3 : UCIP\_SP\_2021\_62272\_66505.jpg

Overview of levee crown at crossing.

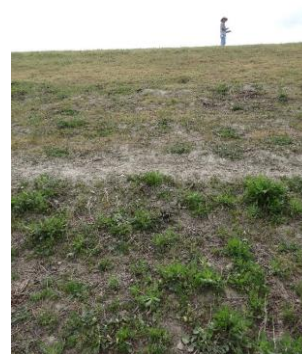
Photo 1 of 3 : UCIP\_SP\_2021\_62273\_66530.jpg

FS\_ID:62273  
 DS\_ID:19885  
 EP\_NO: N/A  
 Repair Type: Non-Urgent  
 Crossing Status: Found  
 UCIP Comments: 04/17/2014 Need to contact owner to determine status of crossing. Waterward side is buried and not accessible. Landward side headwall is blocked by dense vegetation. Recommend confirming status of flap gate on waterward side and removing dense vegetation from landward side. (O. Magana - DWR UCIP)  
 FIELD\_STRUCT\_DESC: 36-inch corrugated metal gravity drainage pipe through the levee, 16.6 feet below the crown. Flap gate on the waterside (WS) end. [Additional Reference(s): DWR Levee Log, 2002 (HLM 15.93), listed as a 36-inch corrugated metal pipe (CMP). USACE San Joaquin O&M Manual, Unit 601 Part 1 (SJR601.1), 1967, Revised 25 May 2011, (HLM 15.91), listed as a 36-inch CMP]  
 FS Date: 4/17/2014

View of waterward side, Photo 1 of 3.

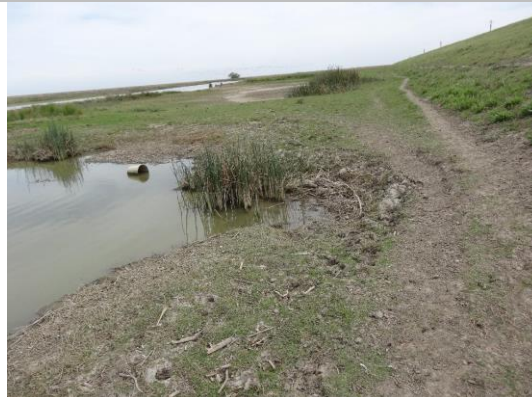
Photo 2 of 3 : UCIP\_SP\_2021\_62273\_66526.jpg

View of waterward side, photo 2 of 3.

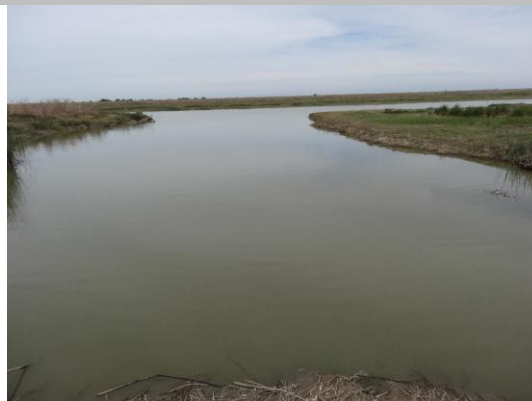
Photo 3 of 3 : UCIP\_SP\_2021\_62273\_66529.jpg

View of waterward side, photo 3 of 3.

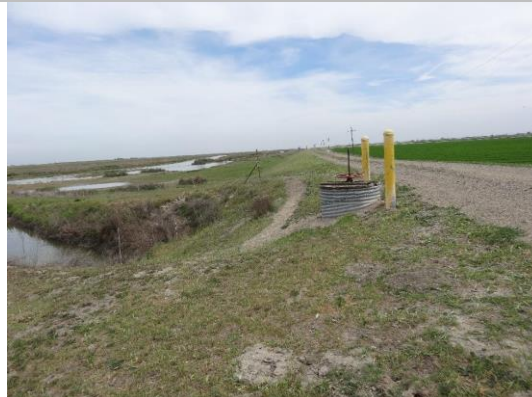
Photo 1 of 3 : UCIP\_SP\_2021\_62274\_66541.jpg

Comment Code						
Inspector Comment						
FS_ID:62274 DS_ID:19559 EP_NO: N/A Repair Type: Non-Urgent Crossing Status: Found UCIP Comments: 04/17/2014 Need to contact owner to determine status of crossing. Unable to confirm pipe diameter. (O. Magana - DWR UCIP) FIELD_STRUCT_DESC: 36-inch corrugated metal irrigation siphon pipe through the levee, 5.9 feet below the crown. Slide gate on the waterside (WS). Siphon extends under channel. [Additional Reference(s): USACE San Joaquin O&M Manual, Unit 601 Part 1 (SJR601.1), 1967, Revised 25 May 2011, (HLM 16.49), listed as a 36-inch corrugated metal pipe (CMP), siphon under channel]. FS Date: 4/17/2014

View of waterward side.

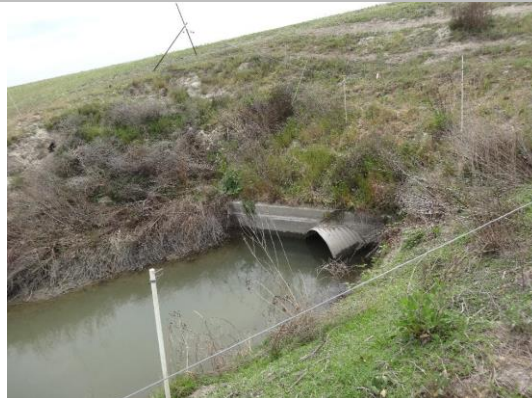
Photo 2 of 3 : UCIP\_SP\_2021\_62274\_66539.jpg

Concrete headwall and pipe visible on waterward side.

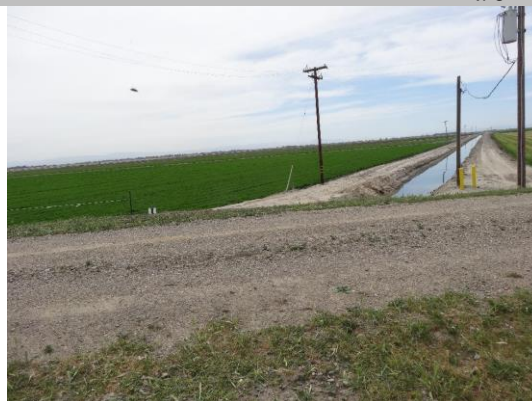
Photo 3 of 3 : UCIP\_SP\_2021\_62274\_66540.jpg

View of landward side, photo 1 of 2.

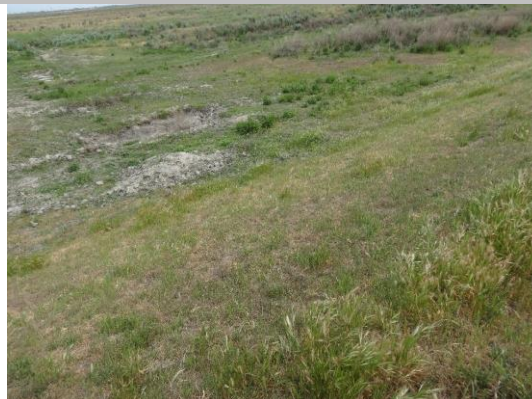
Photo 1 of 3 : UCIP\_SP\_2021\_62269\_66562.jpg

FS\_ID:62269  
DS\_ID:19888  
EP\_NO: 3040  
Repair Type: Urgent  
Crossing Status: Found  
UCIP Comments: 11/01/2018 Signs of pipe leakage (wet spot) visible in floodway. Crossing remains Urgent due to potential leakage along the pipe. Recommend internal inspection to determine pipe integrity through the levee. (O. Magana - DWR UCIP)07/20/2016 Same as previous inspection. Dense vegetation prevents proper inspection along floodway. (O. Magana - DWR UCIP)04/17/2014 Need to contact owner. Leak on waterward toe approximately 15 feet from toe. Good candidate for video or pressure test. (O. Magana - DWR UCIP)  
FIELD\_STRUCT\_DESC: 48-inch corrugated metal irrigation siphon pipe through the levee, 8.8 feet below the crown. Slide gate in a pipe riser on the landside (LS) slope, not the waterside (WS) slope. Concrete headwall on the LS, not the WS. Siphon extends under the channel. 24-inch corrugated metal cleanout pipe at the center of the channel with a metal plate cover. (Plans for construction of two reinforced concrete siphons across the Eastside Bypass authorized under Permit No. 3040, 1959 - Newhall Land and Farming Company). [Additional Reference(s): DWR Levee Log, 2002 (HLM 18.91), listed as a 48-inch corrugated metal pipe (CMP). USACE San Joaquin O&M Manual, Unit 601 Part 1 (SJR601.1), 1967, Revised 25 May 2011, (HLM 18.91), listed as a 48-inch CMP]

View of WS. Channel section exposed near waterward toe.

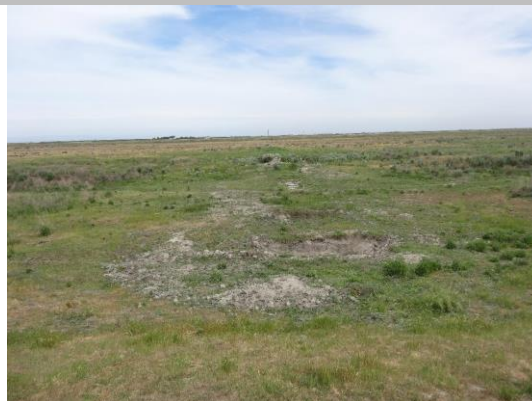
Photo 2 of 3 : UCIP\_SP\_2021\_62269\_66564.jpg

Overview of Eastside Bypass.

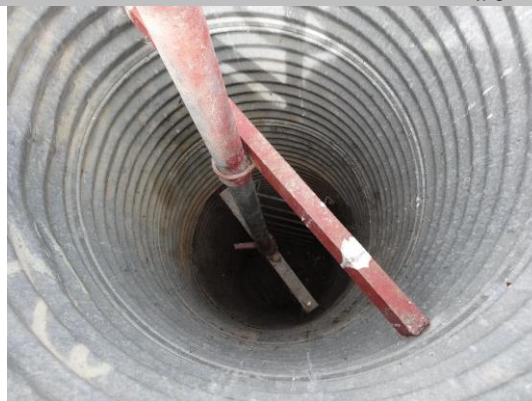
Photo 2 of 3 : UCIP\_SP\_2021\_62277\_66582.jpg

Inside view of CMP riser located on waterward slope.

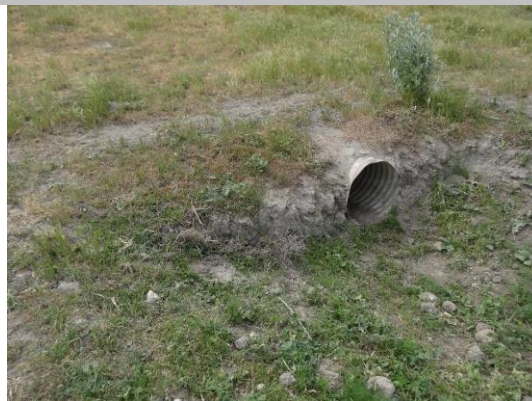
Photo 3 of 3 : UCIP\_SP\_2021\_62277\_66581.jpg

Pipe daylight on waterward side.

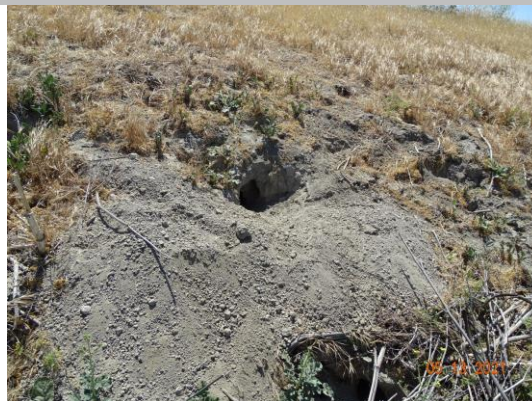
Photo 1 of 1 : SP\_2021\_NA0010\_124\_72\_20210517\_00174.jpg

LM Start	19.07	Rating **	U	Issue No.	72
LM End	19.07	Issue Type +	Ma	Location *	LS
Category	Earthen Levee			GPS Latitude/Longitude	
				Start	End
Item	Animal Control			37.115706 °	37.115706 °
				-120.587036 °	-120.587036 °
DWR ID	DWR_NA0010_06_s_2021_72				
Comment Code					
A3 : No rodents visible, but rodent burrows visible; need to backfill and compact or grout burrows.					
Inspector Comment

Large rodent burrows observed in the landside slope. (Spring 2021)

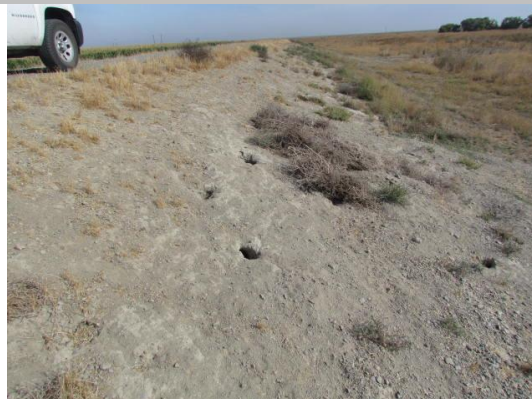
Photo 1 of 1 : SP\_2021\_NA0010\_124\_1211\_20210308\_00038.jpg

LM Start	19.14	Rating **	A/W	Issue No.	1211
LM End	19.14	Issue Type +	Ma	Location *	WS
Category	Earthen Levee			GPS Latitude/Longitude	
				Start	End
Item	Animal Control			37.114793 °	37.114793 °
				-120.587582 °	-120.587582 °
DWR ID	DWR_NA0010_06_s_2015_1211				
Comment Code					
A1 : Exterminate rodents and backfill and compact or grout burrows.					
Inspector Comment					
Several large rodent holes with more than 2 cubic feet of material were previously noted on the waterside slope.

Looking at several rodent holes on waterward slope. (Fall 2015)

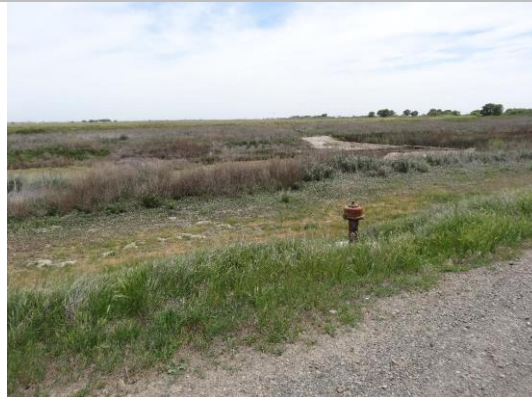
Photo 1 of 3 : UCIP\_SP\_2021\_62278\_66583.jpg

FS\_ID:62278  
DS\_ID:19890  
EP\_NO: N/A  
Repair Type: Non-Urgent  
Crossing Status: Found  
UCIP Comments: 04/17/2014 Dense vegetation limits the inspector's visibility to identify signs of pipe failure (leaks) along the slopes. Recommend removing vegetation along pipe alignment to conduct proper inspection of structure. (O. Magana - DWR UCIP)  
FIELD\_STRUCT\_DESC: 48-inch corrugated metal gravity drainage pipe through the levee, 20 feet below the crown. Slide gate in a pipe riser on the waterside (WS) slope. Riprap along the landside (LS) slope. [Additional Reference(s): DWR Levee Log, 2002 (HLM 19.36), listed as a 48-inch corrugated metal pipe (CMP). USACE San Joaquin O&M Manual, Unit 601 Part 1 (SJR601.1), 1967, Revised 25 May 2011, (HLM 19.36), listed as a 48-inch CMP].  
FS Date: 4/17/2014

View of waterward side.

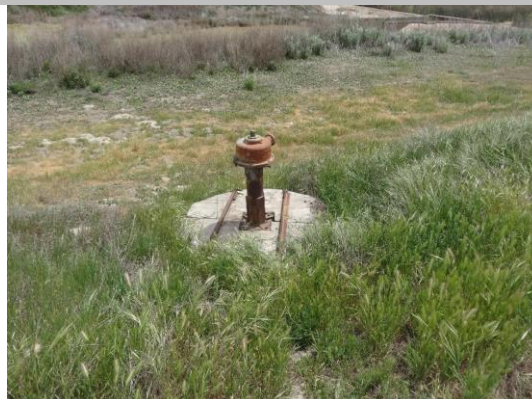
Photo 2 of 3 : UCIP\_SP\_2021\_62278\_66584.jpg

Riser located on waterward slope.

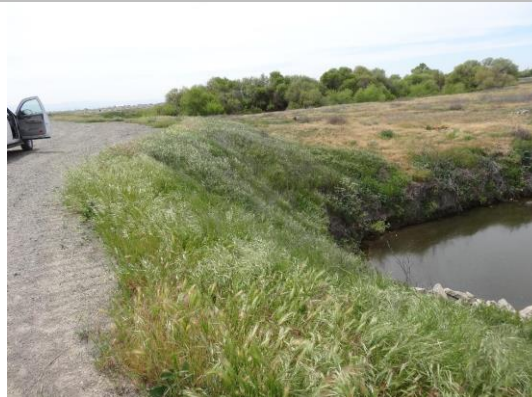
Photo 3 of 3 : UCIP\_SP\_2021\_62278\_66586.jpg

View of landward slope.

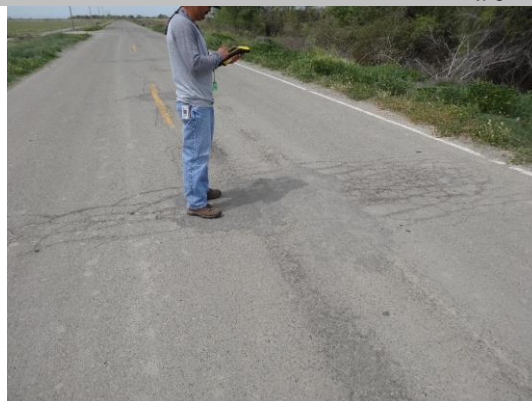
Photo 1 of 3 : UCIP\_SP\_2021\_62279\_66591.jpg

FS\_ID:62279  
DS\_ID:19891  
EP\_NO: N/A  
Repair Type: Non-Urgent  
Crossing Status: Found  
UCIP Comments: 04/17/2014 Dense vegetation limits the inspector's visibility to identify signs of pipe failure (leaks) along the slopes. Recommend removing vegetation along pipe alignment to conduct proper inspection of structure. (O. Magana - DWR UCIP)  
FIELD\_STRUCT\_DESC: 30-inch by 30-inch reinforced concrete box gravity drainage culvert through the levee, 14 feet below the crown. Flap gate on the waterside (WS) end. [Additional Reference(s): DWR Levee Log, 2002 (HLM 19.82), listed as a 2.5-foot by 2.5-foot reinforced concrete box culvert (RCBC). USACE San Joaquin O&M Manual, Unit 601 Part 1 (SJR601.1), 1967, Revised 25 May 2011, (HLM 19.85), listed as a 2.5-foot by 2.5 foot RCBC].  
FS Date: 4/17/2014

Overview of levee crown looking downstream.

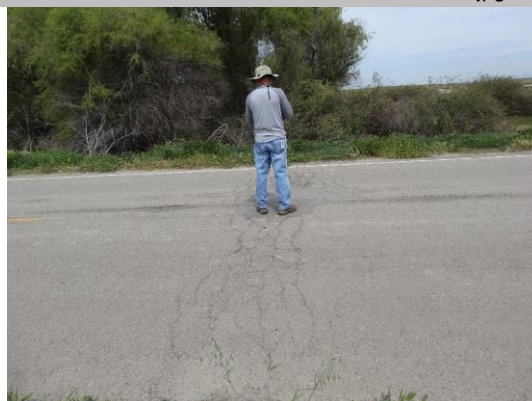
Photo 2 of 3 : UCIP\_SP\_2021\_62279\_66592.jpg

View of levee crown at crossing.

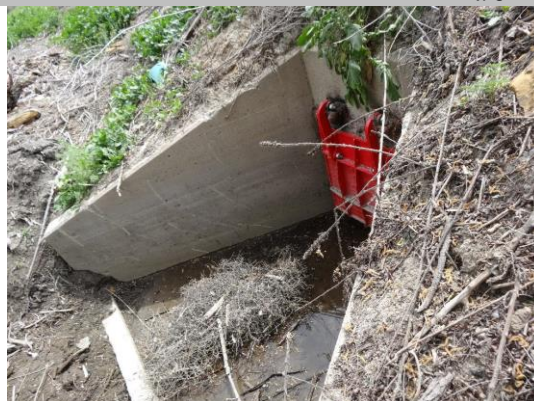
Photo 3 of 3 : UCIP\_SP\_2021\_62279\_66590.jpg

View of "U" concrete headwall located on waterward side.

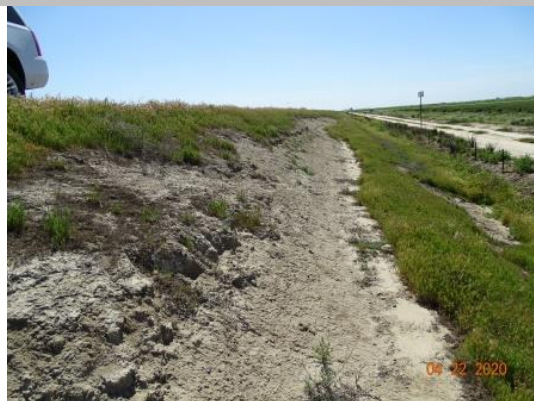
Photo 1 of 1 : SP\_2021\_NA0010\_124\_1209\_20210308\_00037.jpg

LM Start	20.79	Rating **	M	Issue No.	1209
LM End	21.10	Issue Type +	Ma	Location *	LS
Category	Earthen Levee			GPS Latitude/Longitude	
				Start	End
Item	Animal Control			37.113107 °	37.109735 °
				-120.563782 °	-120.560079 °
DWR ID	DWR_NA0010_06_s_2015_1209				
Comment Code					
A2 : Repair the levee slope damaged by livestock and prevent large animal access.					
Inspector Comment					
Erosion on landside slope greater than 3 inches. Erosion caused by livestock.

Erosion on the landside slope from livestock activity. (Spring 2020)

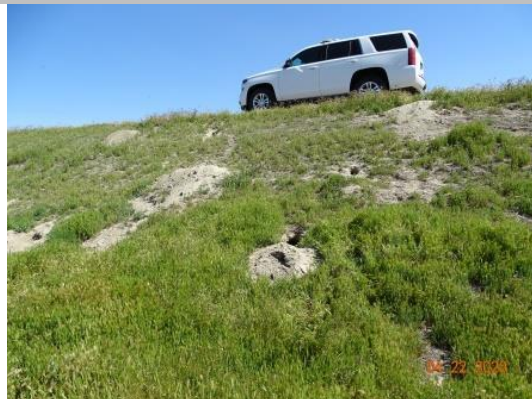
Photo 1 of 1 : SP\_2021\_NA0010\_124\_114\_20210308\_00031.jpg

LM Start	21.39	Rating **	M	Issue No.	114
LM End	21.39	Issue Type +	Ma	Location *	LS
Category	Earthen Levee			GPS Latitude/Longitude	
				Start	End
Item	Animal Control			37.106397 °	37.106397 °
				-120.556727 °	-120.556727 °
DWR ID	DWR_NA0010_06_f _ 2019_114				
Comment Code					
A3 : No rodents visible, but rodent burrows visible; need to backfill and compact or grout burrows.					
Inspector Comment

View of rodent burrows on the landside slope. (Spring 2020)

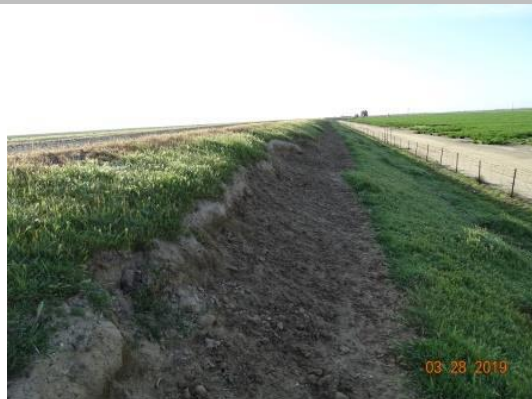
Photo 1 of 1 : SP\_2021\_NA0010\_124\_107\_20210308\_00030.jpg

LM Start	21.71	Rating **	M	Issue No.	107
LM End	21.78	Issue Type +	Ma	Location *	LS
Category	Earthen Levee			GPS Latitude/Longitude	
				Start	End
Item	Animal Control			37.102844 °	37.102002 °
				-120.553160 °	-120.552314 °
DWR ID	DWR_NA0010_06_f _ 2018_107				
Comment Code					
A2 : Repair the levee slope damaged by livestock and prevent large animal access.					
Inspector Comment					
Erosion into levee prism due to livestock activities.

View of erosion in landside levee prism. (Spring 2019)

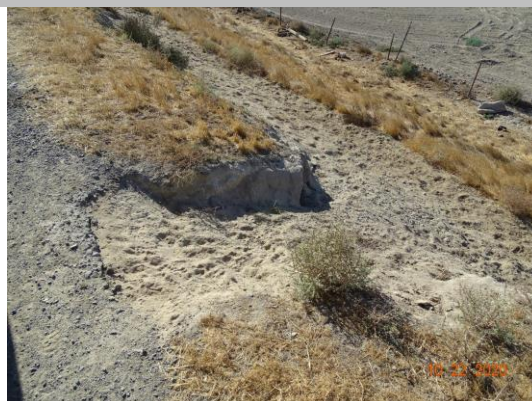
Photo 1 of 1 : SP\_2021\_NA0010\_124\_91\_20210308\_00021.jpg

LM Start	21.88	Rating **	M	Issue No.	91
LM End	22.06	Issue Type +	Ma	Location *	LS
Category	Earthen Levee			GPS Latitude/Longitude	
				Start	End
Item	Animal Control			37.100931 °	37.098894 °
				-120.551230 °	-120.549178 °
DWR ID	DWR_NA0010_06_f _ 2020_91				
Comment Code					
A2 : Repair the levee slope damaged by livestock and prevent large animal access.					
Inspector Comment

Cattle trail damage to the landside slope and shoulder. (Fall 2020)

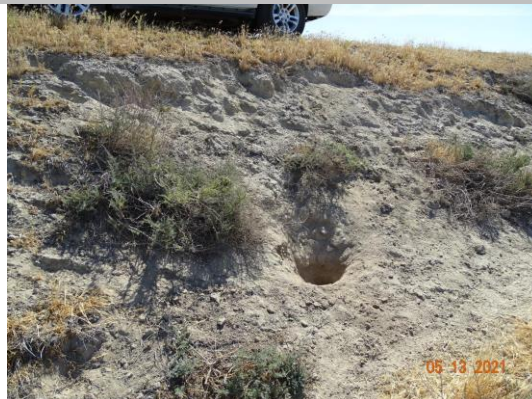
Photo 1 of 1 : SP\_2021\_NA0010\_124\_70\_20210517\_00175.jpg

LM Start	22.15	Rating **	U	Issue No.	70
LM End	22.15	Issue Type +	Ma	Location *	LS
Category	Earthen Levee			GPS Latitude/Longitude	
				Start	End
Item	Animal Control			37.097885 °	37.097885 °
				-120.548108 °	-120.548108 °
DWR ID	DWR_NA0010_06_s_2021_70				
Comment Code					
A3 : No rodents visible, but rodent burrows visible; need to backfill and compact or grout burrows.					
Inspector Comment

View of large rodent burrows in the landside slope. (Spring 2021)

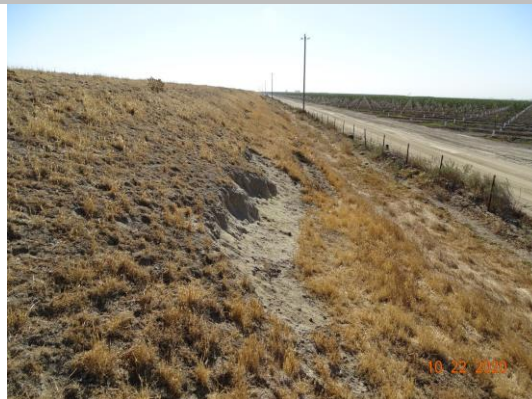
Photo 1 of 1 : SP\_2021\_NA0010\_124\_86\_20210308\_00019.jpg

LM Start	22.41	Rating **	M	Issue No.	86
LM End	22.46	Issue Type +	Ma	Location *	LS
Category	Earthen Levee			GPS Latitude/Longitude	
				Start	End
Item	Animal Control			37.094969 °	37.094479 °
				-120.544964 °	-120.544435 °
DWR ID	DWR_NA0010_06_f_2017_86				
Comment Code					
A2 : Repair the levee slope damaged by livestock and prevent large animal access.					
Inspector Comment					
Erosion greater than 3 inches on landside slope caused by livestock.

Looking upstream along the landside slope. (Fall 2020)

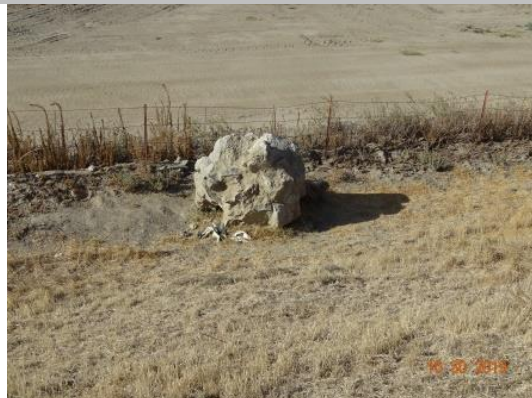
Photo 1 of 1 : SP\_2021\_NA0010\_124\_117\_20210308\_00032.jpg

LM Start	22.87	Rating **	M	Issue No.	117
LM End	22.87	Issue Type +	Ma	Location *	LS
Category	Earthen Levee			GPS Latitude/Longitude	
				Start	End
Item	Encroachments			37.089954 °	37.089954 °
				-120.539535 °	-120.539535 °
DWR ID	DWR_NA0010_06_f _ 2019_117				
Comment Code					
DE : Debris					
Inspector Comment					
Large block of concrete left on the landside toe.

Large concrete block left on the landside toe. (Fall 2019)

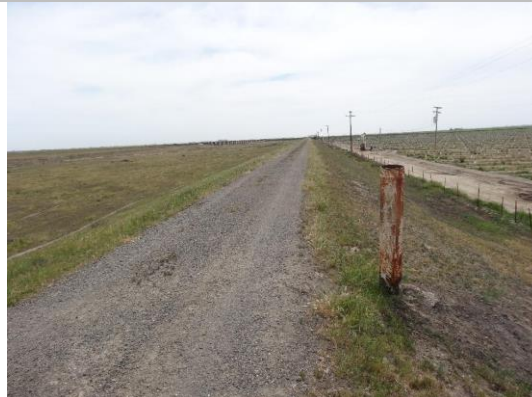
Photo 1 of 3 : UCIP\_SP\_2021\_62281\_61871.jpg

Comment Code					
Inspector Comment					
FS_ID:62281 DS_ID:19879 EP_NO: 13638 Repair Type: Non-Urgent Crossing Status: Found UCIP Comments: 04/17/2014 Need to contact owner to determine status. Crossing has been modified. (O. Magana - DWR UCIP) FIELD_STRUCT_DESC: 16-inch coated steel irrigation discharge pipe through the levee, 3.5 feet below the crown. Cutoff wall around the pipe at the center of the levee. Pump on the waterside (WS). Siphon breaker on the landside (LS) shoulder. Intake trench on the WS. (Plans to install a pump with a 16-inch pipeline over the levee authorized under Permit No. 13638, 1983 - Hamonds Ranch). [Additional Reference(s): DWR Levee Log, 2002 (HLM 23.92), listed as a 16-inch steel pipe] FS Date: 4/17/2014

Overview of levee crown at crossing.

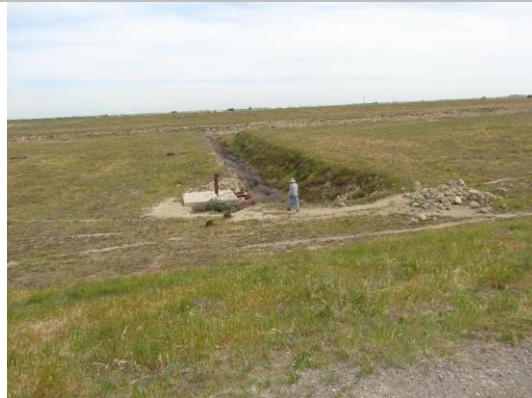
Photo 2 of 3 : UCIP\_SP\_2021\_62281\_61870.jpg

View of waterward side.

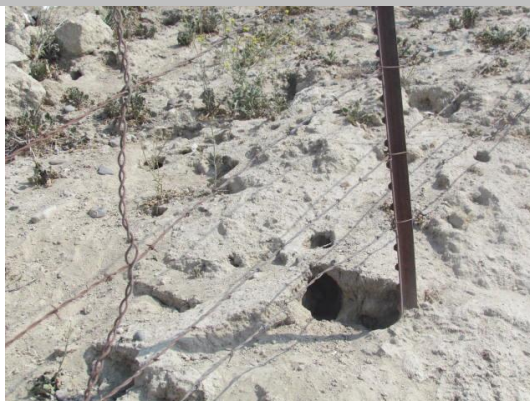
Photo 1 of 1 : SP\_2021\_NA0010\_124\_1208\_20210308\_00036.jpg

LM Start	26.13	Rating **	M	Issue No.	1208
LM End	26.13	Issue Type +	Ma	Location *	LS
Category	Earthen Levee			GPS Latitude/Longitude	
				Start	End
Item	Animal Control			37.054222 °	37.054222 °
				-120.500862 °	-120.500862 °
DWR ID	DWR_NA0010_06_s_2015_1208				
Comment Code					
A3 : No rodents visible, but rodent burrows visible; need to backfill and compact or grout burrows.					
Inspector Comment					
Noted several rodent holes next to and within rock revetment on landside slope.

Rodent holes on landward slope.

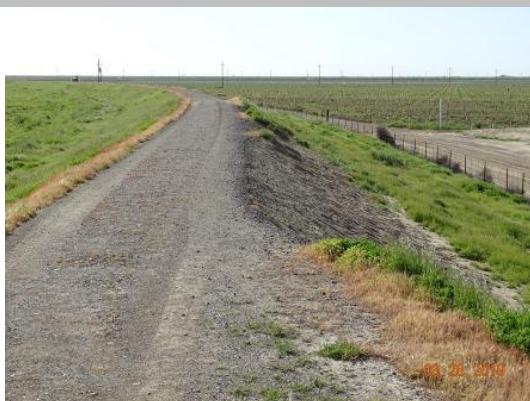
Photo 1 of 1 : SP\_2021\_NA0010\_124\_3\_20210308\_00001.jpg

LM Start	27.43	Rating **	M	Issue No.	3
LM End	27.99	Issue Type +	Ma	Location *	LS
Category	Earthen Levee			GPS Latitude/Longitude	
				Start	End
Item	Animal Control			37.036955 °	37.032762 °
				-120.484395 °	-120.481078 °
DWR ID	DWR_NA0010_06_s_2012_3				
Comment Code					
A2 : Repair the levee slope damaged by livestock and prevent large animal access.					
Inspector Comment					
Landside erosion and slope instability caused by livestock. Erosion greater than 3" in depth on landside slope. Levee crown has narrowed within this reach.

Looking south along landside slope. (Spring 2019)

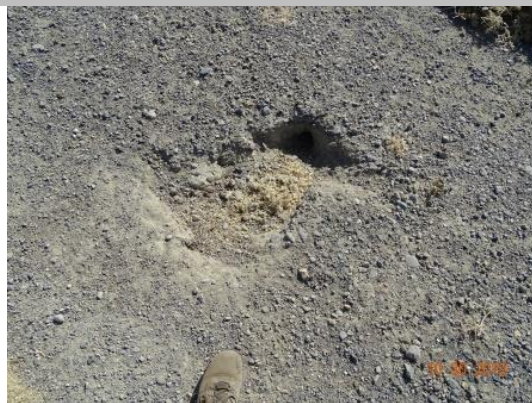
Photo 1 of 1 : SP\_2021\_NA0010\_124\_19\_20210308\_00004.jpg

LM Start	28.47	Rating **	M	Issue No.	19
LM End	28.53	Issue Type +	Ma	Location *	LS
Category	Earthen Levee			GPS Latitude/Longitude	
				Start	End
Item	Animal Control			37.029937 °	37.029977 °
				-120.473384 °	-120.472266 °
DWR ID	DWR_NA0010_06_s_2015_19				
Comment Code					
A3 : No rodents visible, but rodent burrows visible; need to backfill and compact or grout burrows.					
Inspector Comment					
Rodent burrows are also on the crown.

View of rodent burrow in the levee crown. (Fall 2019)

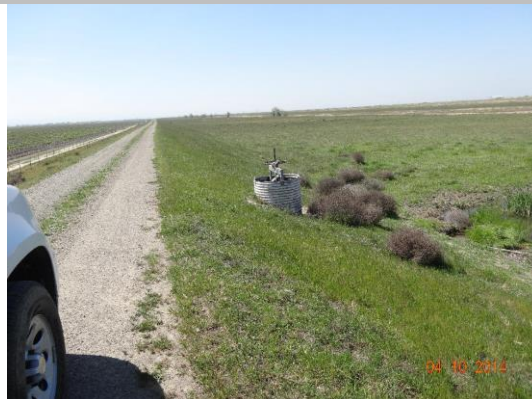
Photo 1 of 3 : UCIP\_SP\_2021\_62283\_66600.jpg

FS\_ID:62283  
DS\_ID:19881  
EP\_NO: N/A  
Repair Type: Non-Urgent  
Crossing Status: Found  
UCIP Comments: 04/10/2014 Dense vegetation limits the inspector's visibility to identify signs of pipe failure (leaks) along the slopes. Recommend removing vegetation along pipe alignment to conduct proper inspection of structure. (O. Magana - DWR UCIP)  
FIELD\_STRUCT\_DESC: 36-inch corrugated metal gravity irrigation pipe through the levee, 12.4 feet below the crown. Slide gate in a 48-inch corrugated metal pipe (CMP) riser on the waterside (WS) slope. Concrete U-shaped headwall on each end. Cobble pad on the landside (LS). [Additional Reference(s): DWR Levee Log, 2002 (HLM 29.34), listed as a 36-inch corrugated metal pipe (CMP). USACE San Joaquin O&M Manual, Unit 601 Part 1 (SJR601.1), 1967, Revised 25 May 2011, (HLM 29.34), listed as a 36-inch CMP].  
FS Date: 4/10/2014

View of waterward side--slide gate inside CMP riser located on waterward slope.

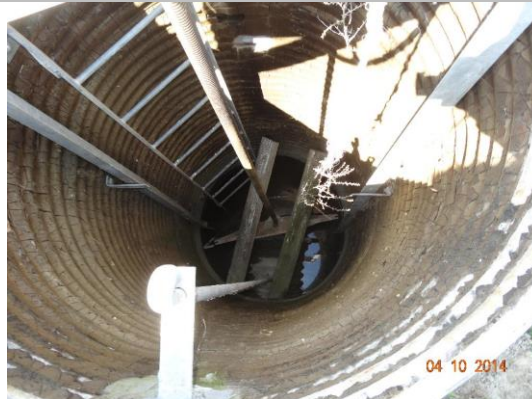
Photo 2 of 3 : UCIP\_SP\_2021\_62283\_66603.jpg

Inside view of CMP riser located on waterward slope.

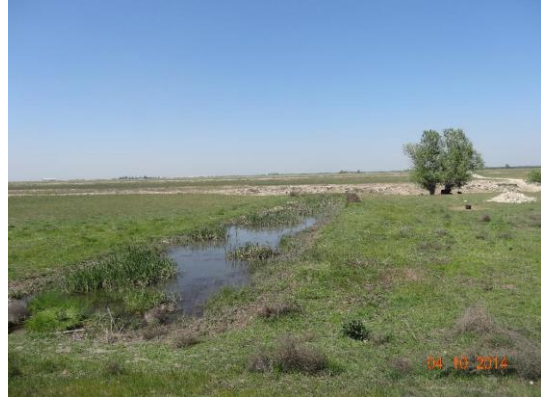
Photo 3 of 3 : UCIP\_SP\_2021\_62283\_66599.jpg

LM Start	<b>29.44</b>	Rating **	M	Issue No.	<b>56 (cont)</b>
LM End	<b>29.44</b>	Issue Type +	En	Location *	
Category	Supplemental		GPS Latitude/Longitude		
			Start	End	
Item	DWR UCIP Field Study		37.030369 °	37.030369 °	
			-120.455969 °	-120.455969 °	
DWR ID	19881

View of waterward side.

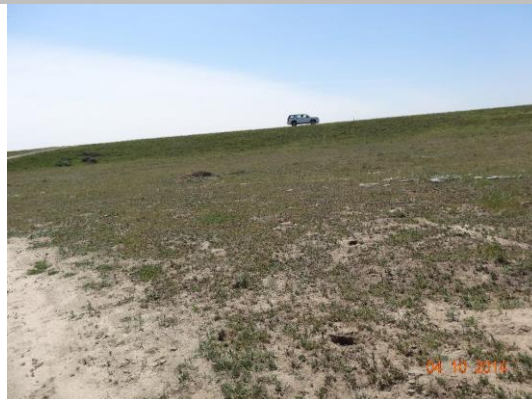
Photo 1 of 3 : UCIP\_SP\_2021\_62284\_66607.jpg

Comment Code					
Inspector Comment					
FS_ID:62284 DS_ID:19882 EP_NO: N/A Repair Type: Non-Urgent Crossing Status: Found UCIP Comments: 04/10/2014 Altered crossing--steel pipe section on landward side and concrete pipe section on waterward side. Joints on waterward side seperated. Need to contact owner to determine status. (O. Magana - DWR UCIP) FIELD_STRUCT_DESC: [Rodunder Siphon Structure] 48-inch reinforced concrete irrigation siphon pipe through the levee, 14.5 feet below the crown. Concrete U-shaped headwall on the outlet structure on the landside (LS) end. Slide gate mounted on the headwall. [Additional Reference(s): DWR Levee Log, 2002 (HLM 30.26), listed as a 48-inch corrugated metal pipe (CMP). USACE San Joaquin O&M Manual, Unit 601 Part 1 (SJR601.1), 1967, Revised 25 May 2011, (HLM 30.27), listed as a 48-inch CMP]. FS Date: 4/10/2014

Overview of waterward side.

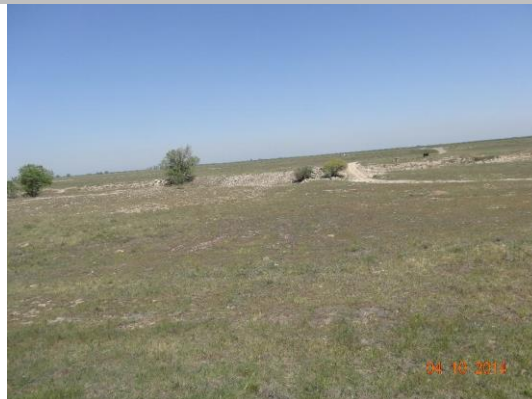
Photo 2 of 3 : UCIP\_SP\_2021\_62284\_66604.jpg

Overview of Eastside Bypass at crossing.
