# Flood Control Project Maintenance Levee Inspections LMA District Cover Sheet

## Lower San Joaquin Levee District

**Flood Control Project Maintenance  
Levee Inspections  
Unit Cover Sheet**

Waterway			Bank	Unit Miles
Unit No. 01 San Joaquin River			Right	22.52
	Spring (March - May)	Summer (June - August)	(September - November) Fall	Winter (December - February)
Unit Maintenance Rating (Fall Only)				
Date of Inspection	5/4/2021 - 5/4/2021			
DWR Inspector	Corey Fujitani			
Accompanied By

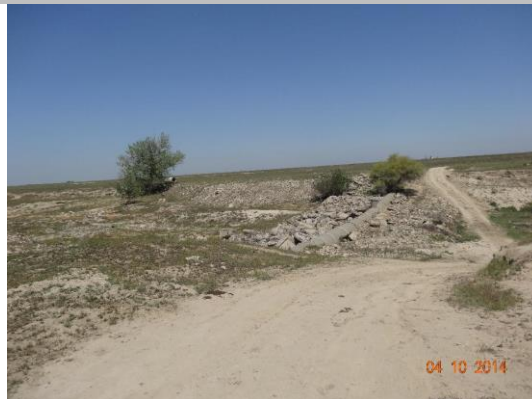
Photo 3 of 3 : UCIP\_SP\_2021\_62284\_66609.jpg

LM Start	<b>30.36</b>	Rating **	M	Issue No.	<b>57 (cont)</b>
LM End	<b>30.36</b>	Issue Type +	En	Location *	
Category	Supplemental		GPS Latitude/Longitude		
			Start	End	
Item	DWR UCIP Field Study		37.027330 °	37.027330 °	
			-120.441498 °	-120.441498 °	
DWR ID	19882

Concrete pipe through Eastside Bypass exposed.

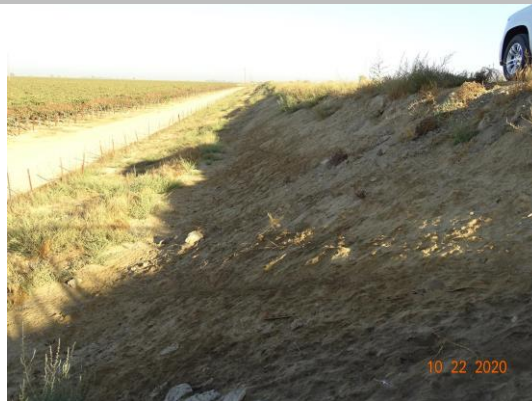
Photo 1 of 1 : SP\_2021\_NA0010\_124\_1207\_20210308\_00035.jpg

LM Start	30.81	Rating **	M	Issue No.	1207
LM End	31.06	Issue Type +	Ma	Location *	LS
Category	Earthen Levee			GPS Latitude/Longitude	
				Start	End
Item	Animal Control			37.021615 °	37.018428 °
				-120.437587 °	-120.435378 °
DWR ID	DWR_NA0010_06_s_2015_1207				
Comment Code					
A2 : Repair the levee slope damaged by livestock and prevent large animal access.					
Inspector Comment					
Landside erosion greater than 1" in depth and greater than 3" in length. Erosion is caused by livestock traffic.

Looking upstream at livestock damage to the landside slope. (Fall 2020)

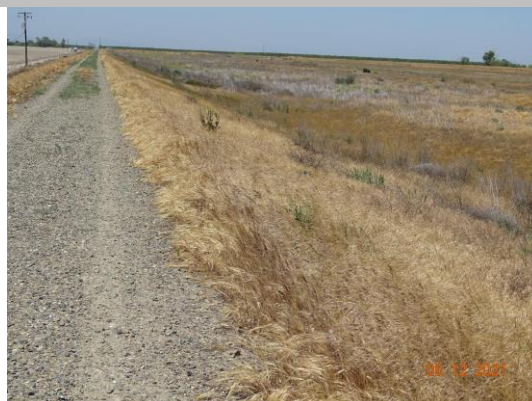
Photo 1 of 1 : SP\_2021\_NA0010\_124\_60\_20210517\_00176.jpg

LM Start	31.06	Rating **	M	Issue No.	60
LM End	36.46	Issue Type +	Ma	Location *	WS
Category	Earthen Levee			GPS Latitude/Longitude	
				Start	End
Item	Vegetation			37.018472 °	36.974171 °
				-120.435393 °	-120.363330 °
DWR ID	DWR_NA0010_06_s_2021_60				
Comment Code					
V1 : Control annual grass and weeds on the levee slopes and easements.					
Inspector Comment

View of vegetation on the waterside slope looking downstream. (Spring 2021)

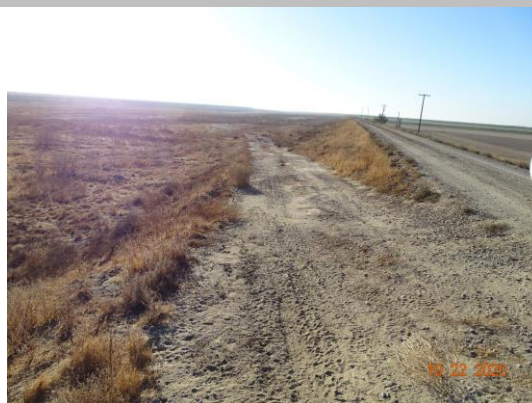
Photo 1 of 1 : SP\_2021\_NA0010\_124\_80\_20210308\_00014.jpg

LM Start	31.10	Rating **	U	Issue No.	80
LM End	31.10	Issue Type +	En	Location *	WS
Category	Earthen Levee			GPS Latitude/Longitude	
				Start	End
Item	Encroachments			37.017907 °	37.017907 °
				-120.434970 °	-120.434970 °
DWR ID	DWR_NA0010_06_s_2017_80				
Comment Code					
RA : Ramp					
Inspector Comment					
Farmer installed ramp on waterside slope.

Looking upstream at ramp on the waterside slope. (Fall 2020)

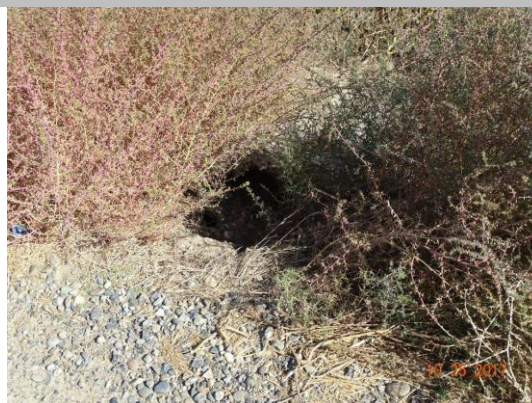
Photo 1 of 1 : SP\_2021\_NA0010\_124\_82\_20210308\_00016.jpg

LM Start	31.14	Rating **	A/W	Issue No.	82
LM End	31.14	Issue Type +	Ma	Location *	WS
Category	Earthen Levee			GPS Latitude/Longitude	
				Start	End
Item	Animal Control			37.017445 °	37.017445 °
				-120.434713 °	-120.434713 °
DWR ID	DWR_NA0010_06_f_2017_82				
Comment Code					
A3 : No rodents visible, but rodent burrows visible; need to backfill and compact or grout burrows.					
Inspector Comment

Looking east at the waterside slope.

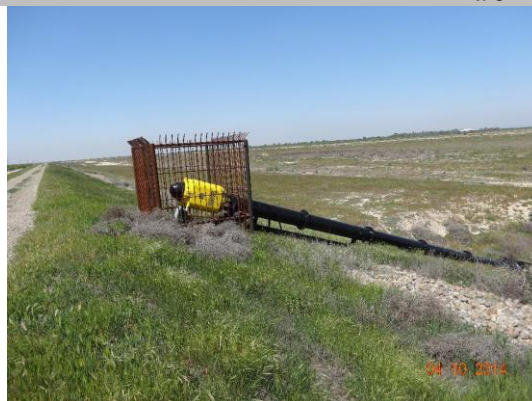
Photo 1 of 3 : UCIP\_SP\_2021\_62285\_61898.jpg

FS\_ID:62285  
DS\_ID:19883  
EP\_NO: 6416-C  
Repair Type: Non-Urgent  
Crossing Status: Found  
UCIP Comments: 04/10/2014 Crossing updated--need to contact owner to determine permit issued by CVFPB for authorized changes. (O. Magana - DWR UCIP)  
FIELD\_STRUCT\_DESC: 20-inch coated steel drainage discharge pipe through the levee, 3.9 feet below the crown. Electrical conduit through the levee. Cutoff wall around pipe at centerline of levee. Capped with a welded plate on the landside (LS) end. Siphon breaker on the apex of the pipe on the LS shoulder. Slant pump on the waterside (WS) slope. (To revise plans for a slant pump and an 18-inch steel pipe through the levee authorized under Permit No. 6416-A, 1975 - Triangle T. Ranch, Inc.). [Additional Reference(s): DWR Levee Log, 2002 (HLM 32.97), listed as a 18-inch steel pipe].  
FS Date: 4/10/2014

View of waterward side--pipe and pump fenced off on waterward slope.

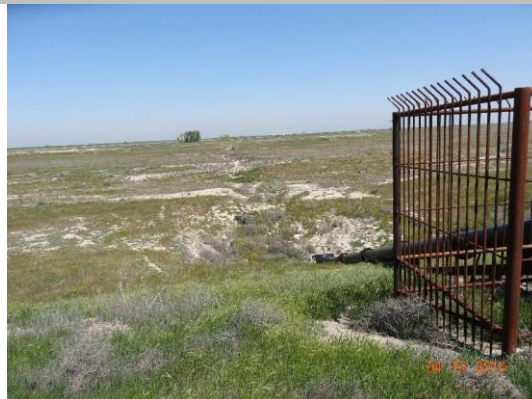
Photo 3 of 3 : UCIP\_SP\_2021\_62285\_61903.jpg

LM Start	33.08	Rating **	M	Issue No.	58 (cont)
LM End	33.08	Issue Type +	En	Location *	
Category	Supplemental			GPS Latitude/Longitude	
				Start	End
Item	DWR UCIP Field Study			36.995672 °	36.995672 °
				-120.412919 °	-120.412919 °
DWR ID	19883

View of Eastside Bypass.

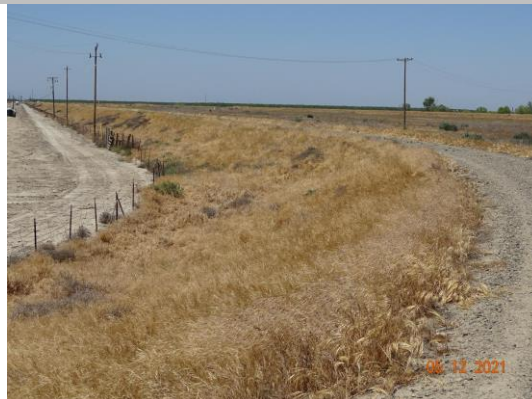
Photo 1 of 1 : SP\_2021\_NA0010\_124\_62\_20210517\_00178.jpg

LM Start	34.04	Rating **	M	Issue No.	62
LM End	36.46	Issue Type +	Ma	Location *	LS
Category	Earthen Levee			GPS Latitude/Longitude	
				Start	End
Item	Vegetation			36.985171 °	36.974171 °
				-120.401278 °	-120.363330 °
DWR ID	DWR_NA0010_06_s_2021_62				
Comment Code					
V1 : Control annual grass and weeds on the levee slopes and easements.					
Inspector Comment

View of vegetation on the landside slope and toe. (Spring 2021)

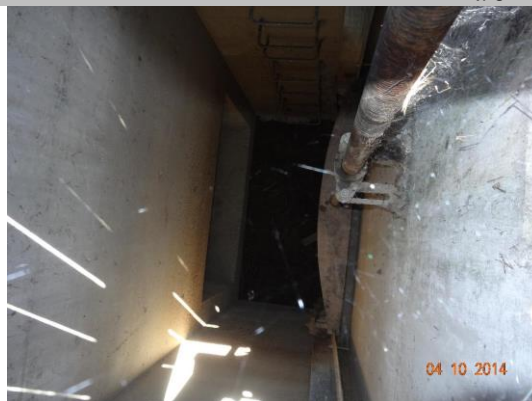
Photo 3 of 3 : UCIP\_SP\_2021\_62287\_66629.jpg

LM Start	35.42	Rating **	M	Issue No.	59 (cont)
LM End	35.42	Issue Type +	En	Location *	
Category	Supplemental			GPS Latitude/Longitude	
				Start	End
Item	DWR UCIP Field Study			36.974509 °	36.974509 °
				-120.382056 °	-120.382056 °
DWR ID	19813

Inside view of concrete box located on waterward slope.

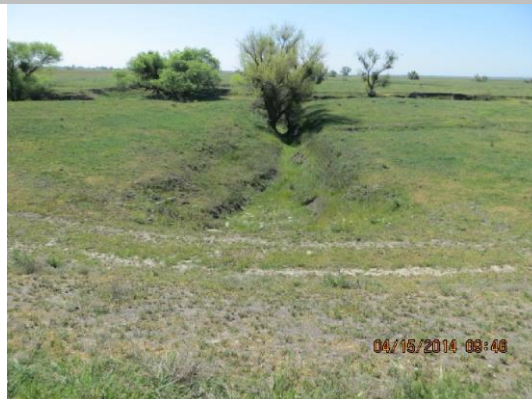
Photo 1 of 3 : UCIP\_SP\_2021\_62031\_60954.jpg

FS\_ID:62031  
DS\_ID:19892  
EP\_NO: N/A  
Repair Type: Non-Urgent  
Crossing Status: Found  
UCIP Comments: 07/20/2016 Inlet blocked off by wooden board. Dense vegetation limits the inspector's visibility to identify signs of pipe failure (leaks) along WS and LS. Crossing downgraded from Urgent to Non-Urgent. (O. Magana - DWR UCIP)04/15/2014 Flapgate partially blocked by soil buildup at WS toe. (W. Wylie - DWR UCIP)  
FIELD\_STRUCT\_DESC: 24-inch corrugated metal gravity drainage pipe through the levee, 10.8 feet below the crown. Flap gate on the waterside (WS) end. Concrete headwall on the landside (LS) end. Concrete U-shaped headwall on the WS end. [Additional Reference(s): DWR Levee Log, 2002 (HLM 0.08), listed as a 24-inch corrugated metal pipe (CMP). USACE San Joaquin O&M Manual, Unit 601 Part 1 (SJR601.1), 1967, (HLM 0.07), listed as a 24-inch CMP].  
FS Date: 7/20/2016

Pipe and headwall at WS toe.

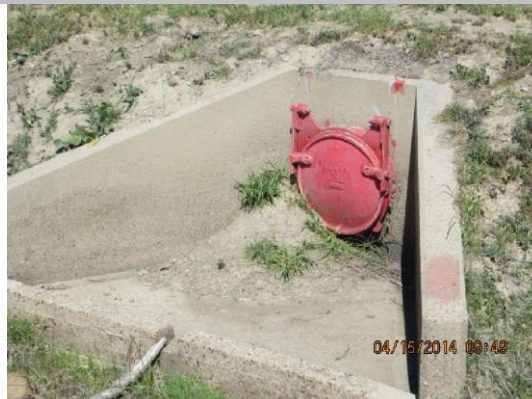
Photo 2 of 3 : UCIP\_SP\_2021\_62031\_60955.jpg

Pipe, headwall, and flapgate at WS toe. Soil buildup partially blocking flapgate.

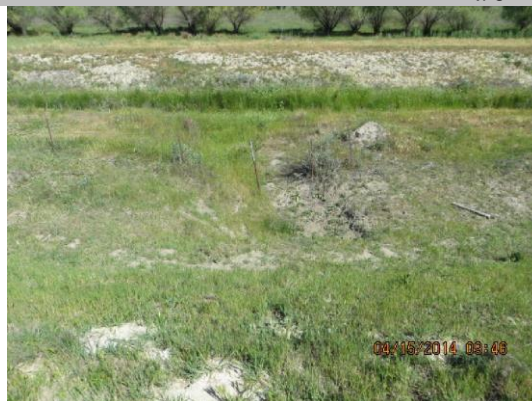
Photo 3 of 3 : UCIP\_SP\_2021\_62031\_60953.jpg

LM Start	<b>0.07</b>	Rating **	M	Issue No.	<b>2 (cont)</b>
LM End	<b>0.07</b>	Issue Type +	Ma	Location *	
Category	Supplemental			GPS Latitude/Longitude	
				Start	End
Item	DWR UCIP LMA Responsibility			37.255897 °	37.255897 °
				-120.771127 °	-120.771127 °
DWR ID	19892

Pipe and headwall at LS toe.

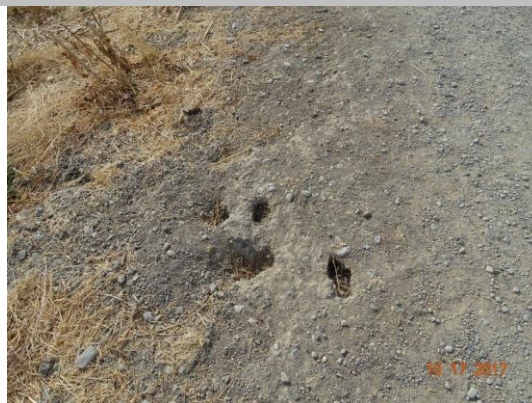
Photo 1 of 1 : SP\_2021\_NA0010\_125\_29\_20210308\_00009.jpg

LM Start	0.24	Rating **	M	Issue No.	29
LM End	0.50	Issue Type +	Ma	Location *	LS
Category	Earthen Levee			GPS Latitude/Longitude	
				Start	End
Item	Animal Control			37.256936 °	37.258722 °
				-120.768472 °	-120.764867 °
DWR ID	DWR_NA0010_07_s_2012_29				
Comment Code					
A3 : No rodents visible, but rodent burrows visible; need to backfill and compact or grout burrows.					
Inspector Comment					
Several rodent holes were noted on the landside and waterside slope and shoulder.

Looking north at landside slope.

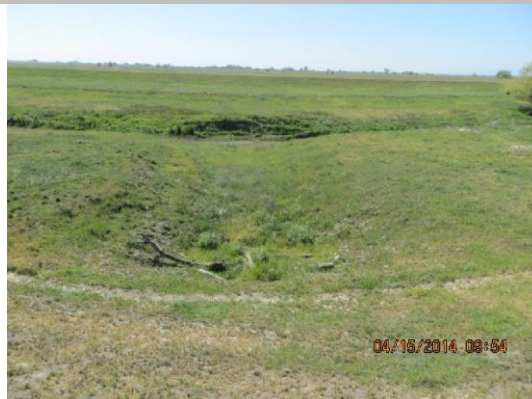
Photo 1 of 3 : UCIP\_SP\_2021\_62044\_60958.jpg

Comment Code						
Inspector Comment						
FS_ID:62044						
DS_ID:19893						
EP_NO: N/A						
Repair Type: No Action Needed						
Crossing Status: Found						
UCIP Comments:						
FIELD_STRUCT_DESC: 24-inch corrugated metal gravity drainage pipe through the levee, 11.1 feet below the crown. Flap gate on the waterside (WS) end. Concrete headwall on the landside (LS) end. Concrete U-shaped headwall on the WS end. [Additional Reference(s): DWR Levee Log, 2002 (HLM 0.34), listed as a 24-inch corrugated metal pipe (CMP). USACE San Joaquin O&M Manual, Unit 601 Part 1 (SJR601.1), 1967, (HLM 0.33), listed as a 24-inch CMP].						
FS Date: 4/15/2014

Pipe and headwall on WS toe.

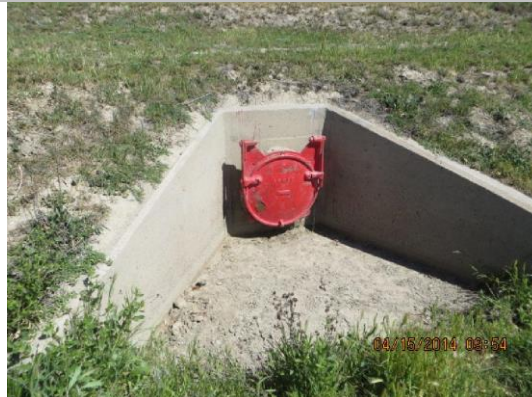
Photo 2 of 3 : UCIP\_SP\_2021\_62044\_60957.jpg

Pipe, headwall, and flapgate on WS toe.

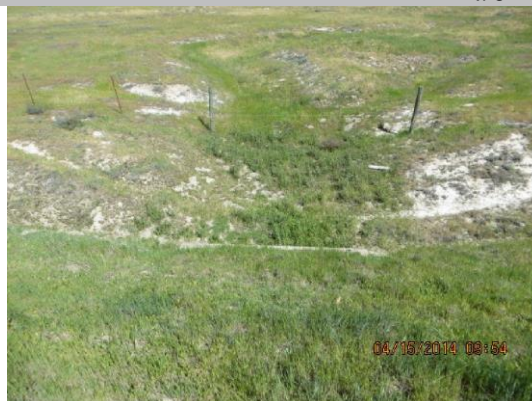
Photo 3 of 3 : UCIP\_SP\_2021\_62044\_60959.jpg

LM Start	0.33	Rating **	A/W	Issue No.	3 (cont)	
LM End	0.33	Issue Type +	Ma	Location *		
Category	Supplemental			GPS Latitude/Longitude		
				Start		End
Item	DWR UCIP LMA Responsibility			37.257691 °	37.257691 °	
				-120.767203 °	-120.767203 °	
DWR ID	19893

Pipe and headwall on LS toe.

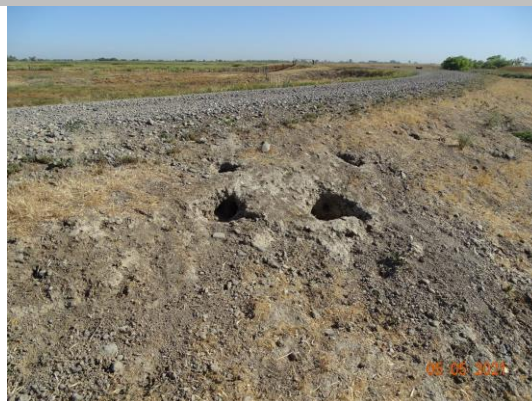
Photo 1 of 1 : SP\_2021\_NA0010\_125\_22\_20210518\_00043.jpg

LM Start	0.44	Rating **	M	Issue No.	22
LM End	0.44	Issue Type +	Ma	Location *	WS
Category	Earthen Levee			GPS Latitude/Longitude	
				Start	End
Item	Animal Control			37.257894 °	37.257894 °
				-120.765231 °	-120.765231 °
DWR ID	DWR_NA0010_07_s_2021_22				
Comment Code					
A3 : No rodents visible, but rodent burrows visible; need to backfill and compact or grout burrows.					
Inspector Comment

View of rodent burrows in the waterside slope and shoulder. (Spring 2021)

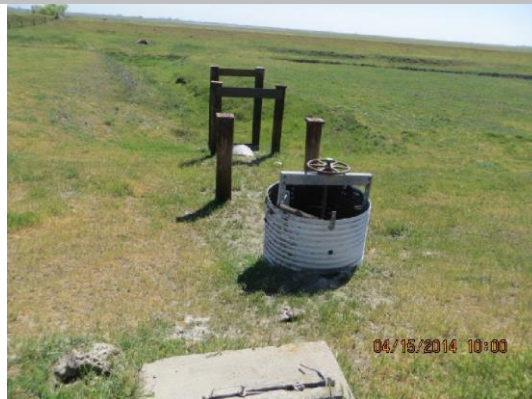
Photo 1 of 3 : UCIP\_SP\_2021\_62042\_60963.jpg

FS\_ID:62042  
DS\_ID:19894  
EP\_NO: N/A  
Repair Type: Non-Urgent  
Crossing Status: Found  
UCIP Comments: 04/15/2014 Slide gate not operable, but left in closed position. Need to reinstall covers over slide gate standpipe. (W. Wylie - DWR UCIP)  
FIELD\_STRUCT\_DESC: 36-inch corrugated metal gravity drainage pipe through the levee, 9.7 feet below the crown. Slide gate in a 48-inch corrugated metal pipe (CMP) riser on the landside (LS) slope. Concrete U-shaped headwall on the LS end. Inlet channel cobble revetted. Dilapidated wooden pier on the waterside (WS). WS slope and outlet ditch cobble revetted. [Additional Reference(s): DWR Levee Log, 2002 (HLM 0.49), listed as a 36-inch corrugated metal pipe (CMP). USACE San Joaquin O&M Manual, Unit 601 Part 1 (SJR601.1), 1967, (HLM 0.49), listed as a 36-inch CMP].  
FS Date: 4/15/2014

Slide gate in CMP riser on WS slope.

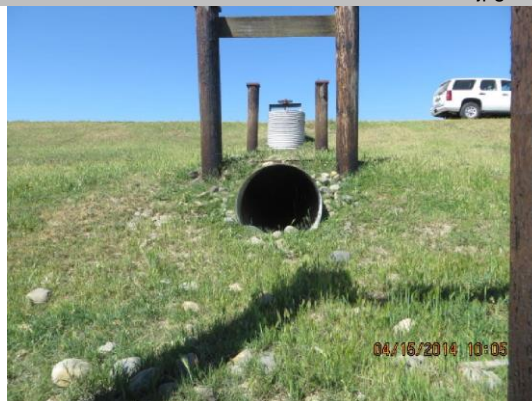
Photo 2 of 3 : UCIP\_SP\_2021\_62042\_60965.jpg

Outlet on WS slope.

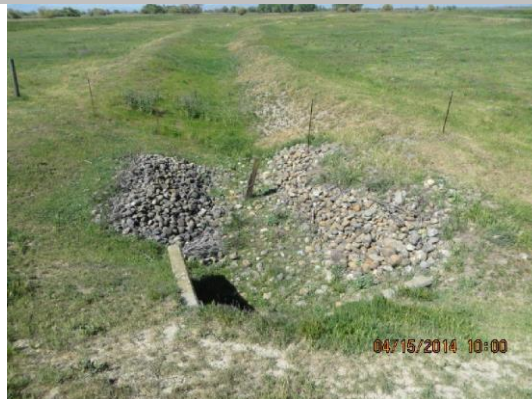
Photo 3 of 3 : UCIP\_SP\_2021\_62042\_60964.jpg

LM Start	<b>0.49</b>	Rating **	M	Issue No.	<b>4 (cont)</b>
LM End	<b>0.49</b>	Issue Type +	Ma	Location *	
Category	Supplemental		GPS Latitude/Longitude		
			Start	End	
Item	DWR UCIP LMA Responsibility		37.258543 °	37.258543 °	
			-120.764728 °	-120.764728 °	
DWR ID	19894

Pipe and headwall on LS toe.

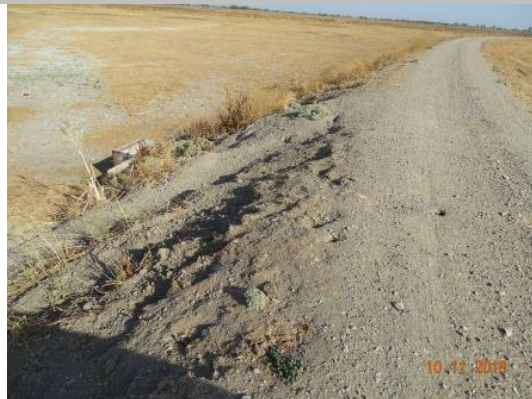
Photo 1 of 1 : SP\_2021\_NA0010\_125\_18\_20210308\_00006.jpg

LM Start	0.53	Rating **	A/W	Issue No.	18
LM End	0.53	Issue Type +	Ma	Location *	LS
Category	Earthen Levee			GPS Latitude/Longitude	
				Start	End
Item	Animal Control			37.259097 °	37.259097 °
				-120.764846 °	-120.764846 °
DWR ID	DWR_NA0010_07_f_2018_18				
Comment Code					
A2 : Repair the levee slope damaged by livestock and prevent large animal access.					
Inspector Comment					
There is livestock damage to the landside slope.

View of damage from livestock looking upstream. (Fall 2018)

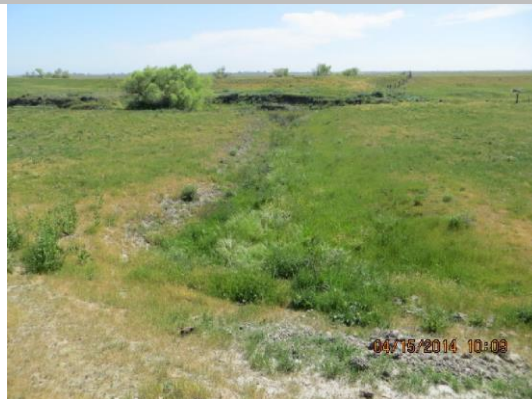
Photo 1 of 3 : UCIP\_SP\_2021\_62045\_60981.jpg

LM Start	0.53	Rating **	A/W	Issue No.	7	
LM End	0.53	Issue Type +	Ma	Location *		
Category	Supplemental			GPS Latitude/Longitude		
				Start		End
Item	DWR UCIP LMA Responsibility			37.259163 °	37.259163 °	
				-120.764860 °	-120.764860 °	
DWR ID	19895					
Comment Code						
Inspector Comment						
FS_ID:62045 DS_ID:19895 EP_NO: N/A Repair Type: No Action Needed Crossing Status: Found UCIP Comments: FIELD_STRUCT_DESC: 24-inch corrugated metal gravity drainage pipe through the levee, 9 feet below the crown. Flap gate on the waterside (WS) end. Concrete headwall with a wooden weir at the inlet on the landside (LS) toe. Concrete U-shaped headwall on the WS toe. [Additional Reference(s): DWR Levee Log, 2002 (HLM 0.53), listed as a 24-inch corrugated metal pipe (CMP). USACE San Joaquin O&M Manual, Unit 601 Part 1 (SJR601.1), 1967, (HLM 0.53), listed as a 24-inch CMP]. FS Date: 4/15/2014

Headwall and flapgate on WS toe.

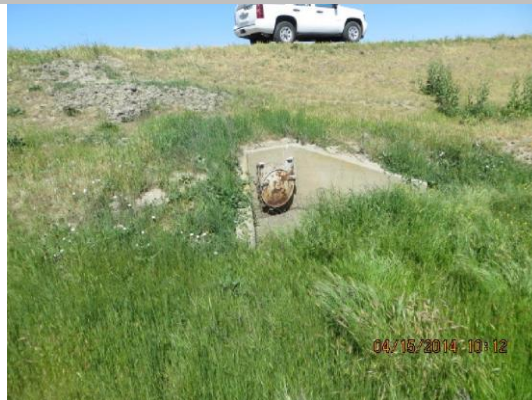
Photo 2 of 3 : UCIP\_SP\_2021\_62045\_60983.jpg

Flapgate on concrete headwall at WS toe.

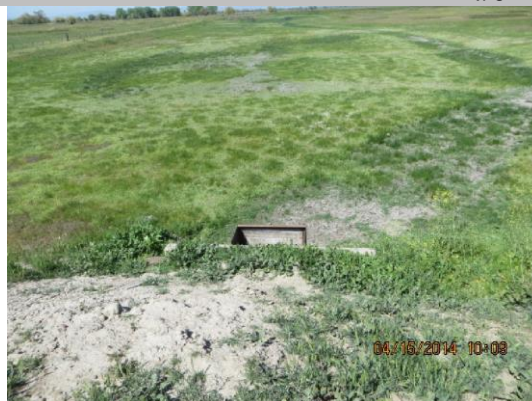
Photo 3 of 3 : UCIP\_SP\_2021\_62045\_60982.jpg

LM Start	0.53	Rating **	A/W	Issue No.	7 (cont)	
LM End	0.53	Issue Type +	Ma	Location *		
Category	Supplemental			GPS Latitude/Longitude		
				Start		End
Item	DWR UCIP LMA Responsibility			37.259163 °	37.259163 °	
				-120.764860 °	-120.764860 °	
DWR ID	19895

Headwall, pipe, and wier on LS toe.

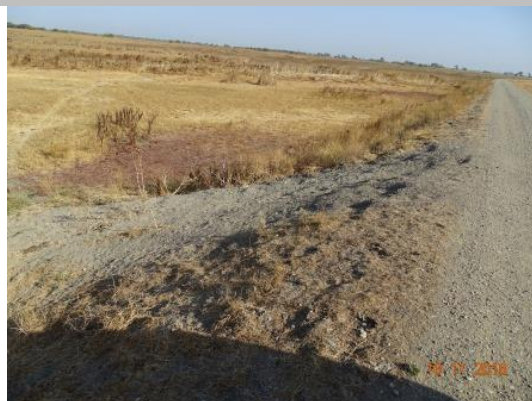
Photo 1 of 1 : SP\_2021\_NA0010\_125\_19\_20210308\_00007.jpg

LM Start	0.70	Rating **	M	Issue No.	19
LM End	0.70	Issue Type +	Ma	Location *	LS
Category	Earthen Levee			GPS Latitude/Longitude	
				Start	End
Item	Animal Control			37.261337 °	37.261337 °
				-120.763303 °	-120.763303 °
DWR ID	DWR_NA0010_07_f_2018_19				
Comment Code					
A2 : Repair the levee slope damaged by livestock and prevent large animal access.					
Inspector Comment					
There is livestock damage to the landside slope.

Damage to landside slope from livestock. (Fall 2018)

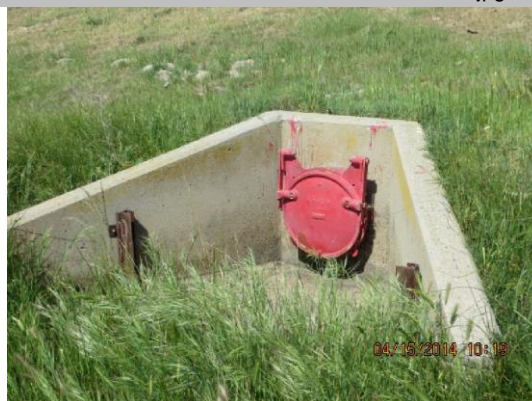
FS\_ID:62035  
DS\_ID:19896  
EP\_NO: N/A  
Repair Type: Non-Urgent  
Crossing Status: Found  
UCIP Comments: 04/15/2014 Need to contact owner. Heavy sediment buildup at inlet due to animal activity should be cleared. (W. Wylie - DWR UCIP)  
FIELD\_STRUCT\_DESC: 24-inch corrugated metal gravity drainage pipe through the levee, 9.8 feet below the crown. Flap gate on the waterside (WS) end. Wooden weir on concrete headwall at the landside (LS) toe. 36-inch concrete riser at the LS toe. Concrete U-shaped headwall on the WS end. Concrete standpipe on the LS. [Additional Reference(s): DWR Levee Log, 2002 (HLM 0.86), listed as a 24-inch corrugated metal pipe (CMP). USACE San Joaquin O&M Manual, Unit 601 Part 1 (SJR601.1), 1967, (HLM 0.85), listed as a 24-inch CMP].  
FS Date: 4/15/2014

Headwall and flapgate on WS toe.

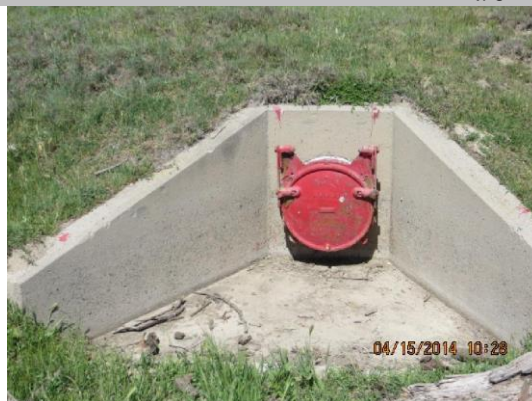
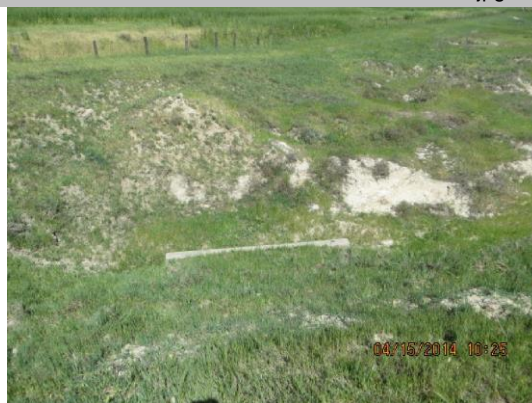
LM Start	0.94	Rating **	A/W	Issue No.	9 (cont)	
LM End	0.94	Issue Type +	Ma	Location *		
Category	Supplemental			GPS Latitude/Longitude		
				Start		End
Item	DWR UCIP LMA Responsibility			37.263950 °	37.263950 °	
				-120.760572 °	-120.760572 °	
DWR ID	19897

Concrete headwall and flapgate at WS toe.

Concrete headwall and pipe on LS toe.

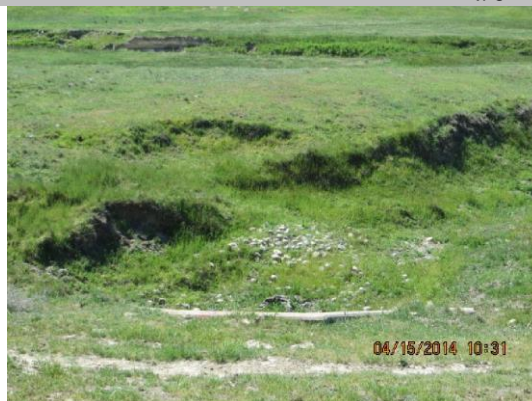
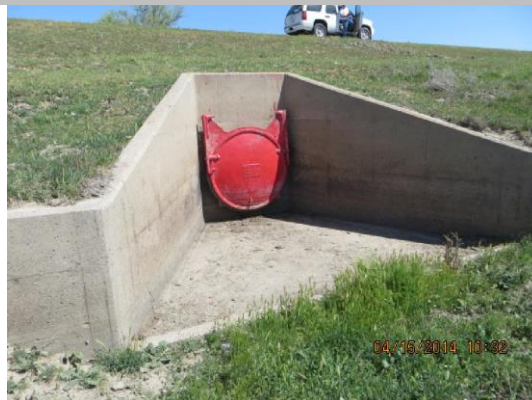
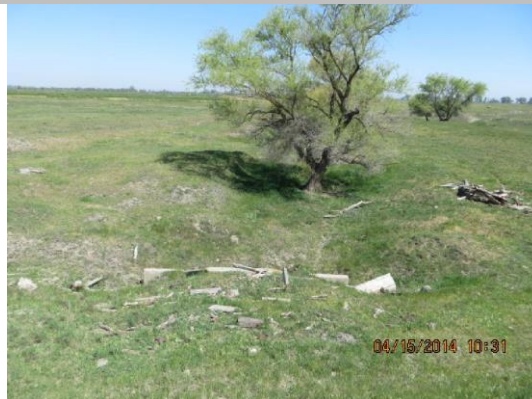
LM Start	1.17	Rating **	A/W	Issue No.	10	
LM End	1.17	Issue Type +	Ma	Location *		
Category	Supplemental			GPS Latitude/Longitude		
				Start		End
Item	DWR UCIP LMA Responsibility			37.264421 °	37.264421 °	
				-120.756683 °	-120.756683 °	
DWR ID	19898					
Comment Code						
Inspector Comment						
FS_ID:62043 DS_ID:19898 EP_NO: N/A Repair Type: No Action Needed Crossing Status: Found UCIP Comments: FIELD_STRUCT_DESC: 48-inch corrugated metal gravity drainage pipe through the levee, 14.6 feet below the crown. Flap gate on the waterside (WS) end. Concrete U-shaped headwall on each end. [Additional Reference(s): DWR Levee Log, 2002 (HLM 1.17), listed as a 48-inch corrugated metal pipe (CMP). USACE San Joaquin O&M Manual, Unit 601 Part 1 (SJR601.1), 1967, (HLM 1.17), listed as a 48-inch CMP]. FS Date: 4/15/2014

Pipe, flapgate, and headwall on WS toe.

Flapgate at headwall on WS toe.

Pipe and headwall on LS toe.

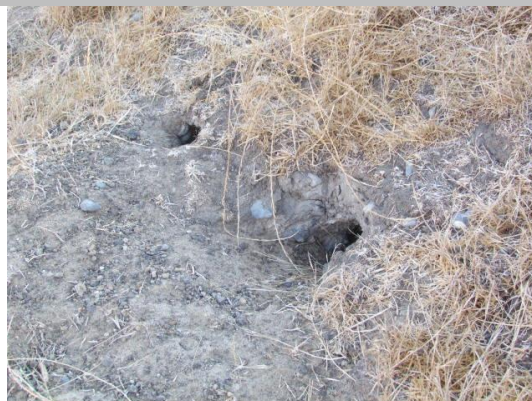
Photo 1 of 1 : SP\_2021\_NA0010\_125\_1\_20210308\_00001.jpg

LM Start	1.22	Rating **	M	Issue No.	1
LM End	1.22	Issue Type +	Ma	Location *	LS
Category	Earthen Levee			GPS Latitude/Longitude	
				Start	End
Item	Animal Control			37.264387 °	37.264387 °
				-120.755805 °	-120.755805 °
DWR ID	DWR_NA0010_07_f _ 2012_1				
Comment Code					
A1 : Exterminate rodents and backfill and compact or grout burrows.					
Inspector Comment					
Borrows observed in the landside slope and berm.

Looking north at several rodent holes on landward slope.

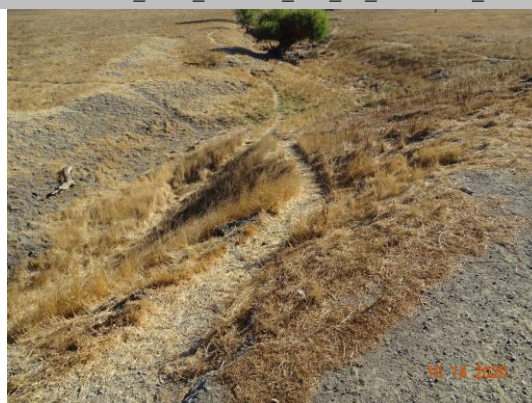
Photo 1 of 1 : SP\_2021\_NA0010\_125\_16\_20210308\_00004.jpg

LM Start	1.49	Rating **	A/W	Issue No.	16
LM End	1.49	Issue Type +	Ma	Location *	LS
Category	Earthen Levee			GPS Latitude/Longitude	
				Start	End
Item	Animal Control			37.263999 °	37.263999 °
				-120.750854 °	-120.750854 °
DWR ID	DWR_NA0010_07_f _ 2017_16				
Comment Code					
A2 : Repair the levee slope damaged by livestock and prevent large animal access.					
Inspector Comment					
Monitor the slope damaged by animal traffic.

Cattle trail on the landside slope. (Fall 2020)

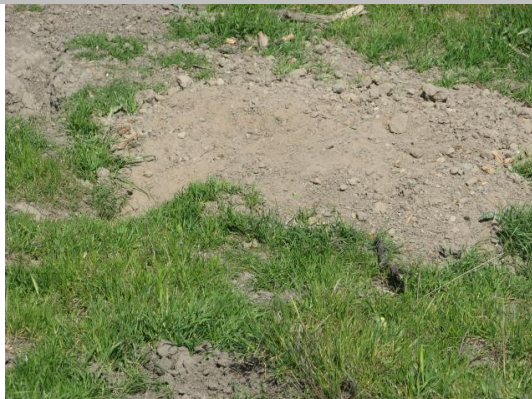
Photo 1 of 1 : SP\_2021\_NA0010\_125\_6\_20210308\_00002.jpg

LM Start	1.50	Rating **	M	Issue No.	6
LM End	1.51	Issue Type +	Ma	Location *	LS
Category	Earthen Levee			GPS Latitude/Longitude	
				Start	End
Item	Animal Control			37.263955 °	37.263885 °
				-120.750751 °	-120.750527 °
DWR ID	DWR_NA0010_07_s_2014_6				
Comment Code					
A1 : Exterminate rodents and backfill and compact or grout burrows.					
Inspector Comment

Looking at typical view of rodent holes within this section. (Spring 2018)

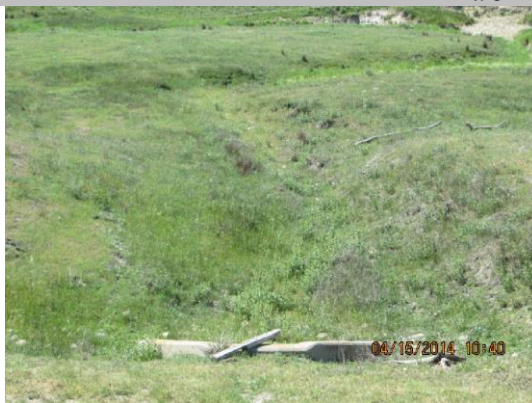
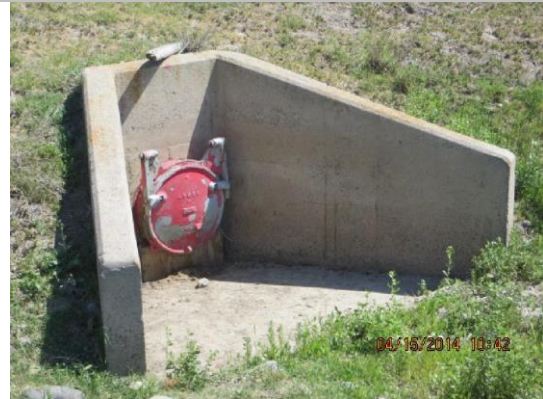
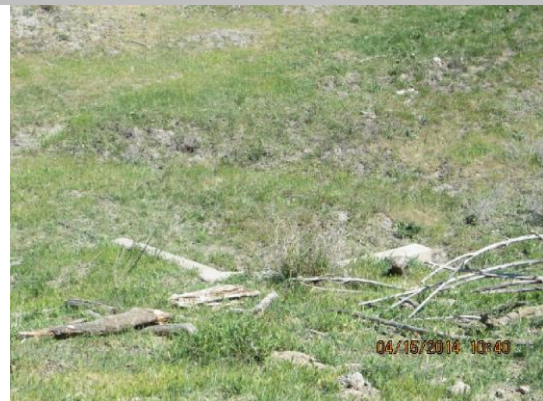
LM Start	1.50	Rating **	A/W	Issue No.	11
LM End	1.50	Issue Type +	Ma	Location *	
Category	Supplemental			GPS Latitude/Longitude	
				Start	End
Item	DWR UCIP LMA Responsibility			37.263917 °	37.263917 °
				-120.750694 °	-120.750694 °
DWR ID	19902				
Comment Code					
Inspector Comment					
FS_ID:62038 DS_ID:19902 EP_NO: N/A Repair Type: No Action Needed Crossing Status: Found UCIP Comments: FIELD_STRUCT_DESC: 24-inch corrugated metal gravity drainage pipe through the levee, 14 feet below the crown. Flap gate on the waterside (WS) end. Concrete U-shaped headwall on each end. [Additional Reference(s): DWR Levee Log, 2002 (HLM 1.51), listed as a 24-inch corrugated metal pipe (CMP). USACE San Joaquin O&M Manual, Unit 601 Part 1 (SJR601.1), 1967, (HLM 1.51), listed as a 24-inch CMP]. FS Date: 4/15/2014

Pipe, headwall and flapgate on WS toe.

Headwall and pipe on LS toe.

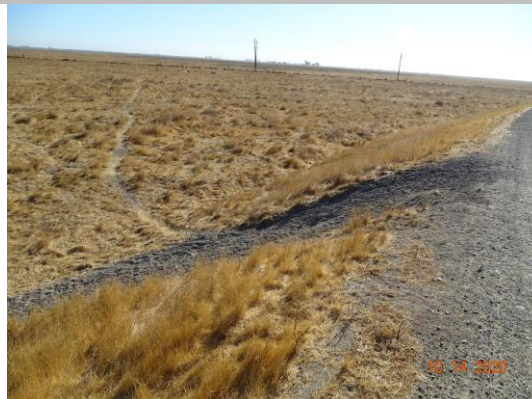
Photo 1 of 1 : SP\_2021\_NA0010\_125\_21\_20210308\_00008.jpg

LM Start	1.90	Rating **	M	Issue No.	21
LM End	1.90	Issue Type +	Ma	Location *	LS
Category	Earthen Levee			GPS Latitude/Longitude	
				Start	End
Item	Animal Control			37.261379 °	37.261379 °
				-120.744228 °	-120.744228 °
DWR ID	DWR_NA0010_07_f_2018_21				
Comment Code					
A2 : Repair the levee slope damaged by livestock and prevent large animal access.					
Inspector Comment

View of damage to the landside slope. (Fall 2020)

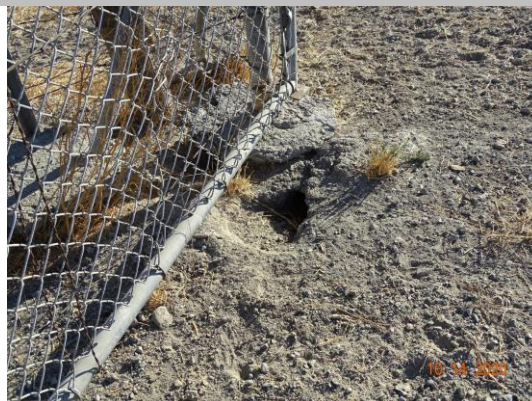
Photo 1 of 1 : SP\_2021\_NA0010\_125\_12\_20210308\_00003.jpg

LM Start	2.09	Rating **	M	Issue No.	12
LM End	2.09	Issue Type +	Ma	Location *	LS
Category	Earthen Levee			GPS Latitude/Longitude	
				Start	End
Item	Animal Control			37.259187 °	37.259187 °
				-120.742551 °	-120.742551 °
DWR ID	DWR_NA0010_07_f _ 2018_12				
Comment Code					
A3 : No rodents visible, but rodent burrows visible; need to backfill and compact or grout burrows.					
Inspector Comment					
Rodent activity is noted next to the fence post.

View of rodent hole at the fence post on the landside shoulder. (Fall 2020)

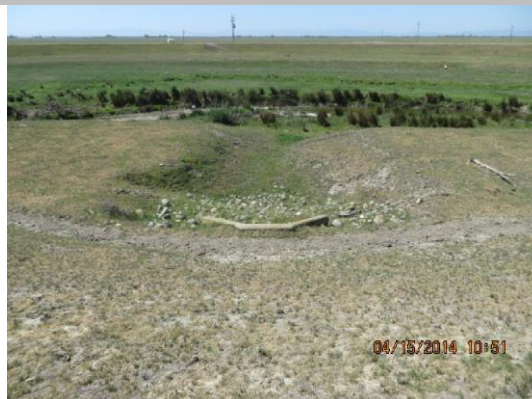
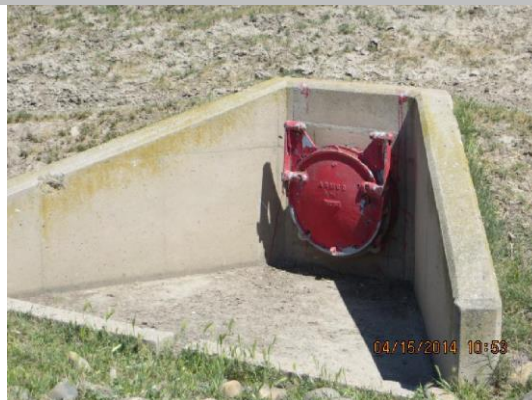
Comment Code						
Inspector Comment						
FS_ID:62039						
DS_ID:19899						
EP_NO: N/A						
Repair Type: No Action Needed						
Crossing Status: Found						
UCIP Comments:						
FIELD_STRUCT_DESC: 24-inch corrugated metal gravity drainage pipe through the levee, 9.5 feet below the crown. Flap gate on the waterside (WS) end. Concrete headwall on the landside (LS) end. Concrete U-shaped headwall on the WS end. [Additional Reference(s): DWR Levee Log, 2002 (HLM 2.49), listed as a 24-inch corrugated metal pipe (CMP). USACE San Joaquin O&M Manual, Unit 601 Part 1 (SJR601.1), 1967, (HLM 2.48), listed as a 24-inch CMP].						
FS Date: 4/15/2014

Headwall and flapgate on WS toe.

Concrete headwall and flapgate at WS toe.

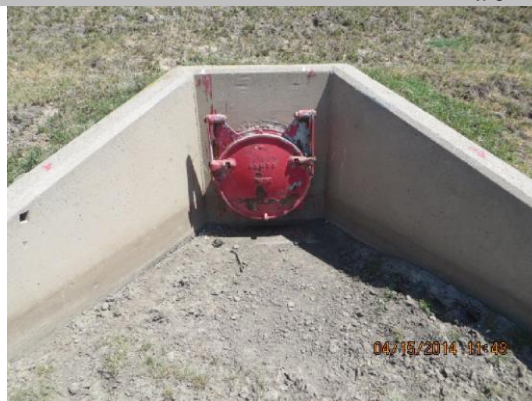
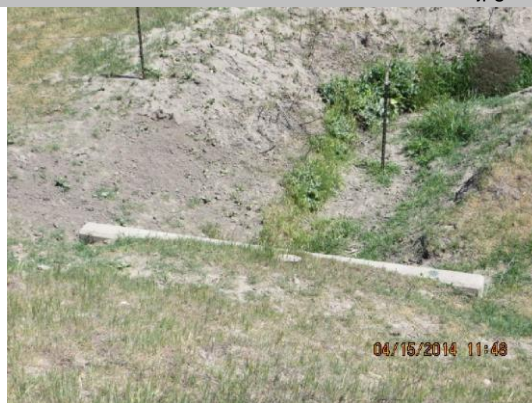
LM Start	<b>2.63</b>	Rating **	A/W	Issue No.	<b>14 (cont)</b>
LM End	<b>2.63</b>	Issue Type +	Ma	Location *	
Category	Supplemental		GPS Latitude/Longitude		
			Start	End	
Item	DWR UCIP LMA Responsibility		37.254832 °	37.254832 °	
			-120.734918 °	-120.734918 °	
DWR ID	19900

Concrete headwall and flapgate on WS toe.

Concrete headwall and pipe at LS toe.

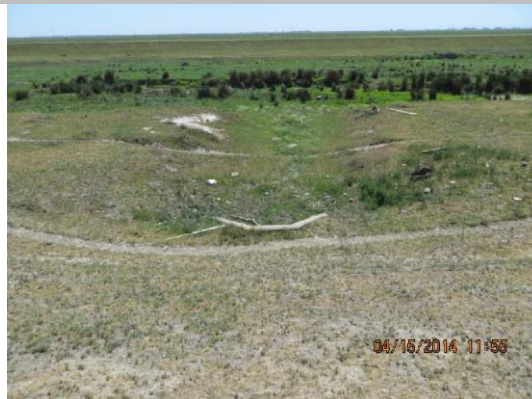
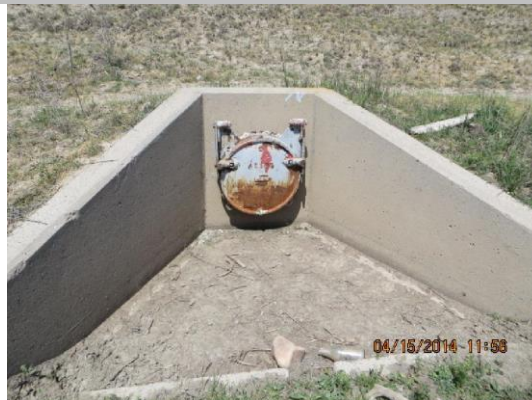
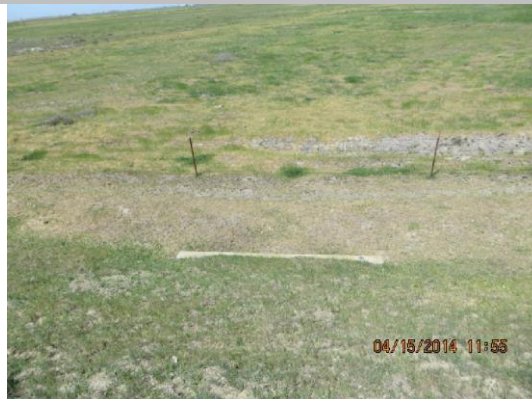
FS\_ID:62041  
DS\_ID:19901  
EP\_NO: N/A  
Repair Type: Non-Urgent  
Crossing Status: Found  
UCIP Comments: 04/15/2014 Some sediment buildup at landward toe and inside pipe--recommend clearing. (W. Wylie - DWR UCIP)  
FIELD\_STRUCT\_DESC: 24-inch corrugated metal gravity drainage pipe through the levee, 10.4 feet below the crown. Flap gate on the waterside (WS) end. Concrete headwall on the landside (LS) end. Concrete U-shaped headwall on the WS end. [Additional Reference(s): DWR Levee Log, 2002 (HLM 3.09), listed as a 24-inch corrugated metal pipe (CMP). USACE San Joaquin O&M Manual, Unit 601 Part 1 (SJR601.1), 1967, (HLM 3.09), listed as a 24-inch CMP].  
FS Date: 4/15/2014

Headwall, pipe, and flapgate on WS toe.

Headwall and pipe on LS toe.

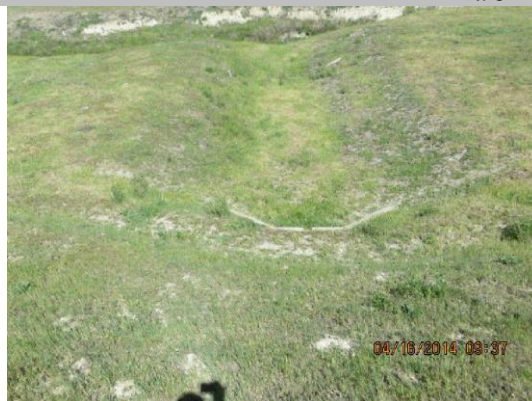
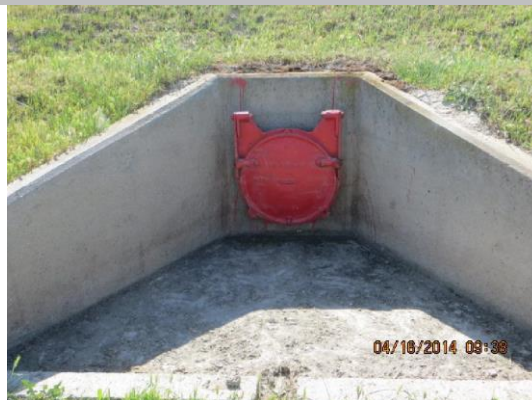
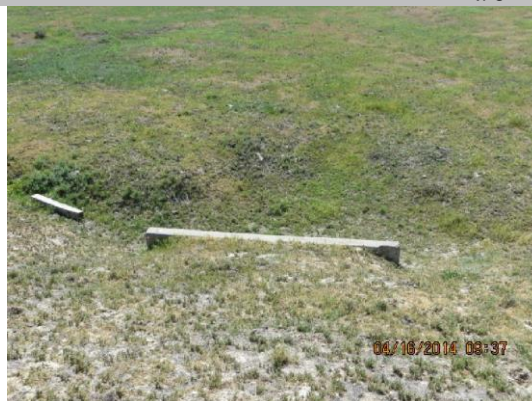
Comment Code						
Inspector Comment						
FS_ID:62046						
DS_ID:19903						
EP_NO: N/A						
Repair Type: No Action Needed						
Crossing Status: Found						
UCIP Comments:						
FIELD_STRUCT_DESC: 24-inch corrugated metal gravity drainage pipe through the levee, 9.6 feet below the crown. Flap gate on the waterside (WS) end. Concrete headwall on the landside (LS) end. Concrete U-shaped headwall on the WS end. [Additional Reference(s): DWR Levee Log, 2002 (HLM 0.23), listed as a 24-inch corrugated metal pipe (CMP). USACE San Joaquin O&M Manual, Unit 601 Part 1 (SJR601.1), 1967, (HLM 0.23), listed as a 24-inch CMP].						
FS Date: 4/16/2014

Headwall and flapgate on WS toe.

Concrete headwall on LS toe.

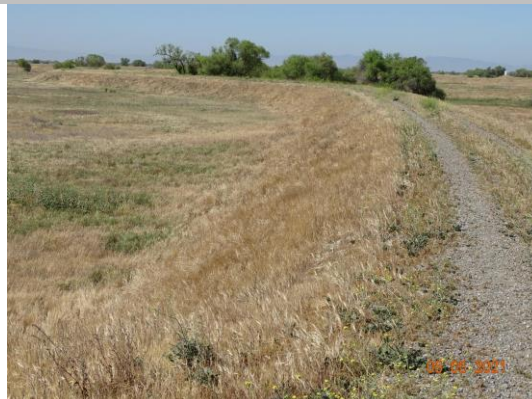
Photo 1 of 1 : SP\_2021\_NA0010\_126\_23\_20210518\_00046.jpg

LM Start	0.57	Rating **	M	Issue No.	23
LM End	0.88	Issue Type +	Ma	Location *	LS
Category	Earthen Levee			GPS Latitude/Longitude	
				Start	End
Item	Vegetation			37.258587 °	37.262263 °
				-120.763583 °	-120.760829 °
DWR ID	DWR_NA0010_08_s_2021_23				
Comment Code					
V1 : Control annual grass and weeds on the levee slopes and easements.					
Inspector Comment

View of the landside slope looking downstream. (Spring 2021)

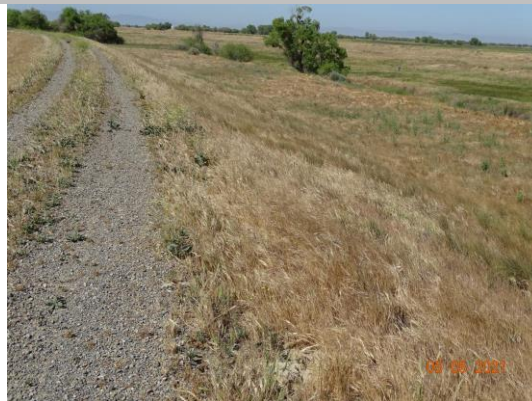
Photo 1 of 1 : SP\_2021\_NA0010\_126\_27\_20210518\_00045.jpg

LM Start	0.57	Rating **	M	Issue No.	27
LM End	0.88	Issue Type +	Ma	Location *	WS
Category	Earthen Levee			GPS Latitude/Longitude	
				Start	End
Item	Vegetation			37.258587 °	37.262263 °
				-120.763583 °	-120.760829 °
DWR ID	DWR_NA0010_08_s_2021_27				
Comment Code					
V1 : Control annual grass and weeds on the levee slopes and easements.					
Inspector Comment

Looking downstream along the waterside slope. (Spring 2021)

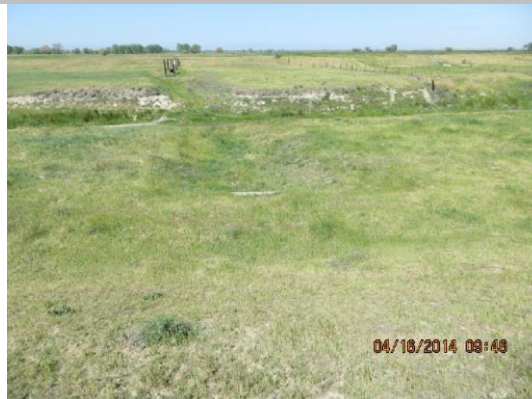
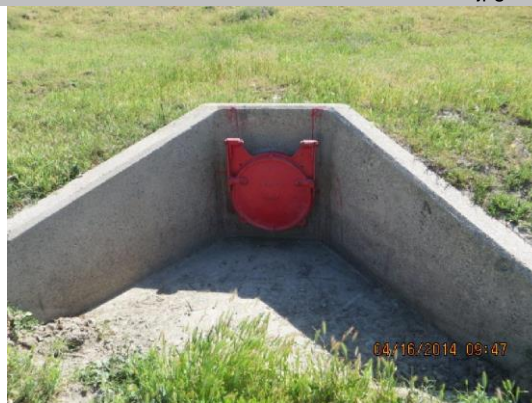
LM Start	0.57	Rating **	A/W	Issue No.	4
LM End	0.57	Issue Type +	Ma	Location *	
Category	Supplemental			GPS Latitude/Longitude	
				Start	End
Item	DWR UCIP LMA Responsibility			37.258604 °	37.258604 °
				-120.763588 °	-120.763588 °
DWR ID	19904				
Comment Code					
Inspector Comment					
FS_ID:62047 DS_ID:19904 EP_NO: N/A Repair Type: No Action Needed Crossing Status: Found UCIP Comments: FIELD_STRUCT_DESC: 24-inch corrugated metal gravity drainage pipe through the levee, 12.4 feet below the crown. Flap gate on the waterside (WS) end. Concrete headwall on each end. [Additional Reference(s): DWR Levee Log, 2002 (HLM 0.55), listed as a 24-inch corrugated metal pipe (CMP). USACE San Joaquin O&M Manual, Unit 601 Part 1 (SJR601.1), 1967, (HLM 0.57), listed as a 24-inch CMP]. FS Date: 4/16/2014

Pipe, flapgate and headwall on WS toe.

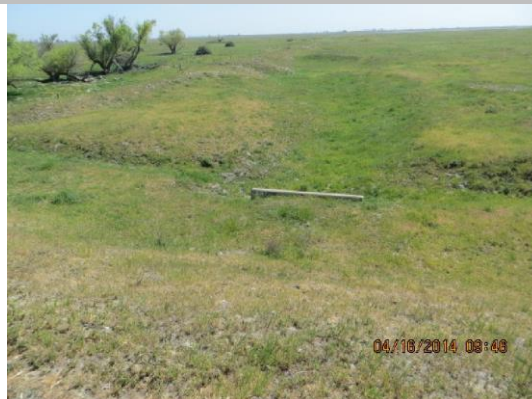
Photo 3 of 3 : UCIP\_SP\_2021\_62047\_61074.jpg

Pipe and headwall on LS toe.

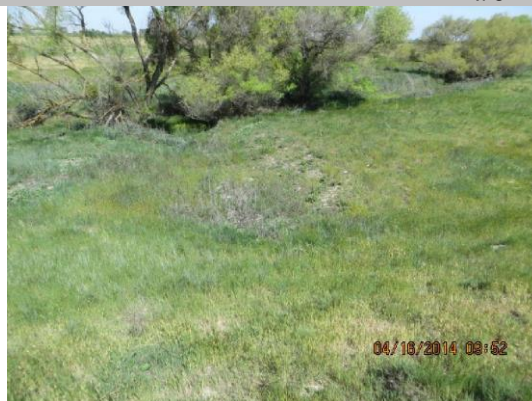
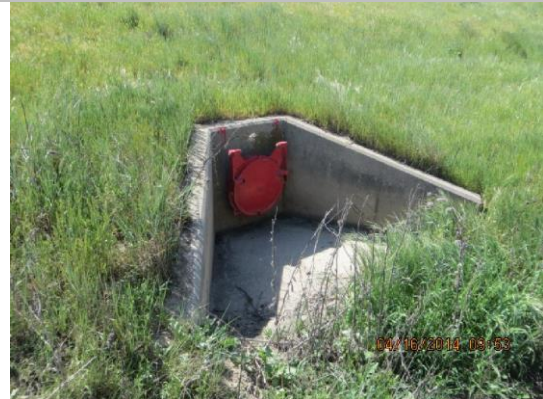
FS\_ID:62048  
DS\_ID:19905  
EP\_NO: N/A  
Repair Type: No Action Needed  
Crossing Status: Found  
UCIP Comments:  
FIELD\_STRUCT\_DESC: 24-inch corrugated metal gravity drainage pipe through the levee, 10 feet below the crown. Flap gate on the waterside (WS) end. Concrete headwall on each end. [Additional Reference(s): DWR Levee Log, 2002 (HLM 0.70), listed as a 24-inch corrugated metal pipe (CMP). USACE San Joaquin O&M Manual, Unit 601 Part 1 (SJR601.1), 1967, (HLM 0.72), listed as a 24-inch CMP].  
FS Date: 4/16/2014

Headwall and flapgate at WS toe.

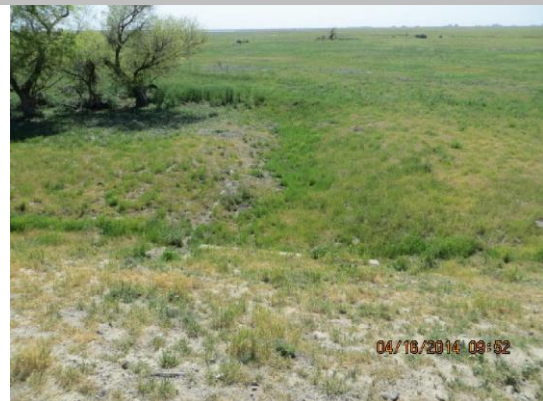
Photo 3 of 3 : UCIP\_SP\_2021\_62048\_61079.jpg

Concrete headwall on LS toe.

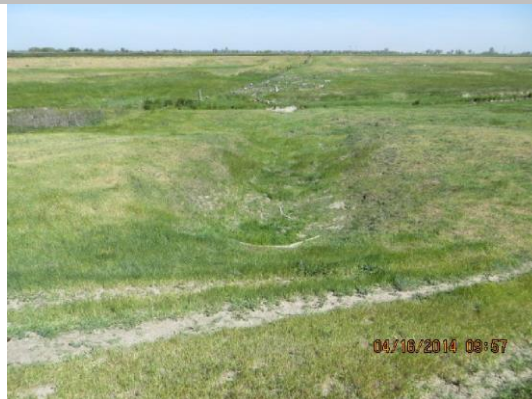
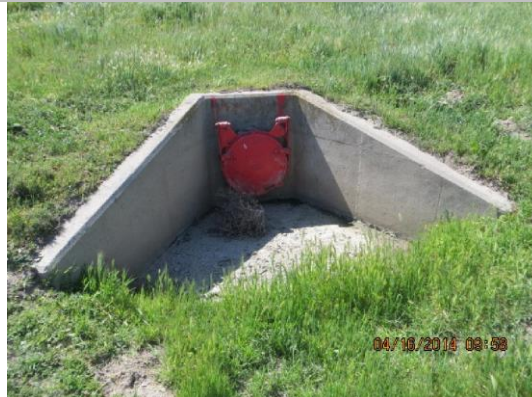
Comment Code						
Inspector Comment						
FS_ID:62049						
DS_ID:19832						
EP_NO: N/A						
Repair Type: Non-Urgent						
Crossing Status: Found						
UCIP Comments: 04/16/2014 Some sediment buildup at inlet on LS toe. (W. Wylie - DWR UCIP)						
FIELD_STRUCT_DESC: 24-inch corrugated metal gravity drainage pipe through the levee, 11.5 feet below the crown. Flap gate on the waterside (WS) end. Concrete headwall on each end. [Additional Reference(s): DWR Levee Log, 2002 (HLM 0.88), listed as a 24-inch corrugated metal pipe (CMP). USACE San Joaquin O&M Manual, Unit 601 Part 1 (SJR601.1), 1967, (HLM 0.89), listed as a 24-inch CMP].						
FS Date: 4/16/2014

Headwall, pipe, and flapgate on WS toe.

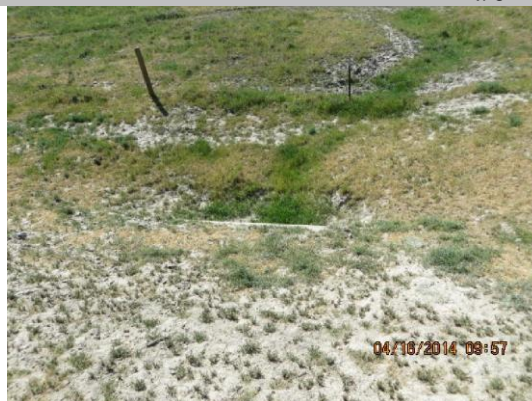
Photo 3 of 3 : UCIP\_SP\_2021\_62049\_61085.jpg

Pipe and headwall on LS toe.

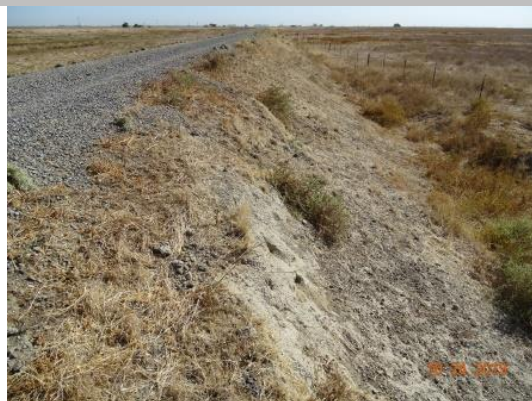
Photo 1 of 1 : SP\_2021\_NA0010\_126\_28\_20210308\_00008.jpg

LM Start	1.21	Rating **	M	Issue No.	28
LM End	1.21	Issue Type +	Ma	Location *	LS
Category	Earthen Levee			GPS Latitude/Longitude	
				Start	End
Item	Animal Control			37.263179 °	37.263179 °
				-120.755444 °	-120.755444 °
DWR ID	DWR_NA0010_08_f_2019_28				
Comment Code					
A2 : Repair the levee slope damaged by livestock and prevent large animal access.					
Inspector Comment

View of slope damage on the landside of the levee looking upstream.  
(Fall 2019)

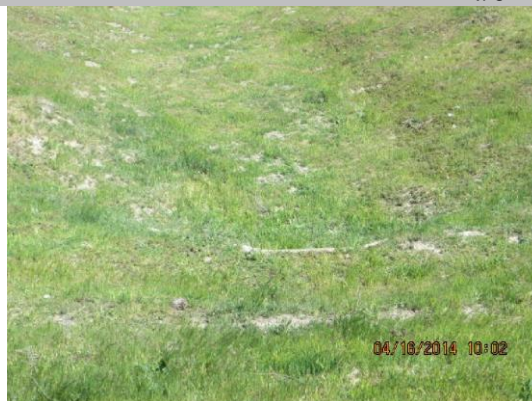
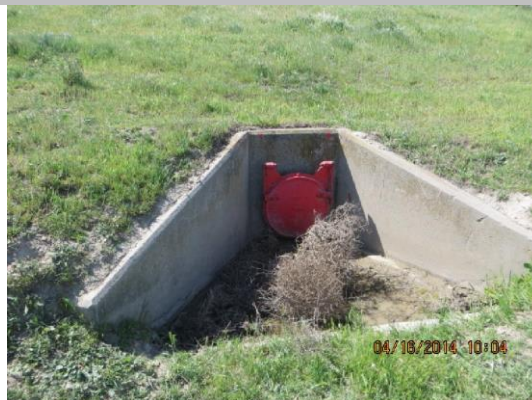
LM Start	1.21	Rating **	M	Issue No.	9	
LM End	1.21	Issue Type +	Ma	Location *		
Category	Supplemental			GPS Latitude/Longitude		
				Start		End
Item	DWR UCIP LMA Responsibility			37.263188 °	37.263188 °	
				-120.755399 °	-120.755399 °	
DWR ID	19833					
Comment Code						
Inspector Comment						
FS_ID:62050 DS_ID:19833 EP_NO: N/A Repair Type: Non-Urgent Crossing Status: Found UCIP Comments: 04/16/2014 Debris blocking landward headwall--recommend clearing. (W. Wylie - DWR UCIP) FIELD_STRUCT_DESC: 24-inch corrugated metal gravity drainage pipe through the levee, 11.6 feet below the crown. Flap gate on the waterside (WS) end. Concrete headwall on each end. [Additional Reference(s): DWR Levee Log, 2002 (HLM 1.20), listed as a 24-inch corrugated metal pipe (CMP). USACE San Joaquin O&M Manual, Unit 601 Part 1 (SJR601.1), 1967, (HLM 1.21), listed as a 24-inch CMP]. FS Date: 4/16/2014

Concrete headwall, pipe, and flapgate on WS toe.

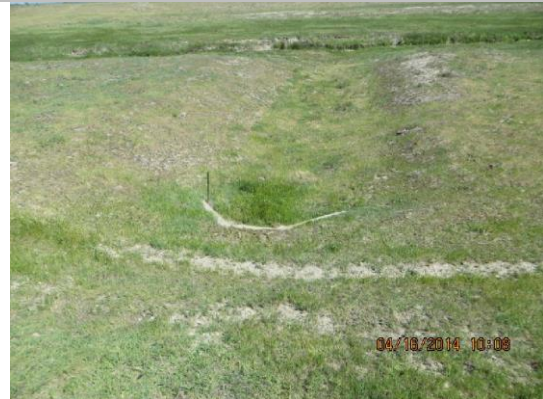
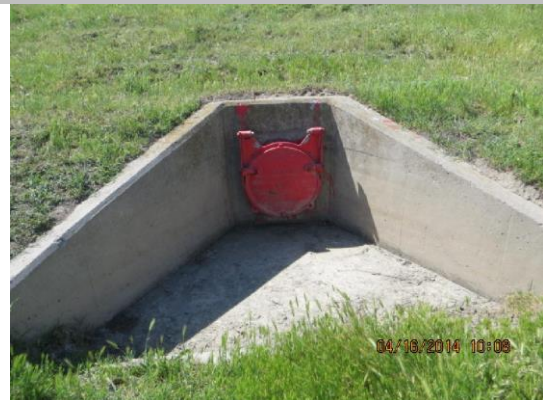
Comment Code						
Inspector Comment						
FS_ID:62051 DS_ID:19834 EP_NO: N/A Repair Type: Non-Urgent Crossing Status: Found UCIP Comments: 04/16/2014 Animal burrows along pipe alignment on LS. Some sediment buildup at LS toe and inside pipe--recommend clearing. (W. Wylie -DWR UCIP) FIELD_STRUCT_DESC: 24-inch corrugated metal gravity drainage pipe through the levee, 11.5 feet below the crown. Flap gate on the waterside (WS) end. Concrete headwall on each end. [Additional Reference(s): DWR Levee Log, 2002 (HLM 1.37), listed as a 24-inch corrugated metal pipe (CMP). USACE San Joaquin O&M Manual, Unit 601 Part 1 (SJR601.1), 1967, (HLM 1.38), listed as a 24-inch CMP]. FS Date: 4/16/2014

Pipe, headwall, and flapgate on WS toe.

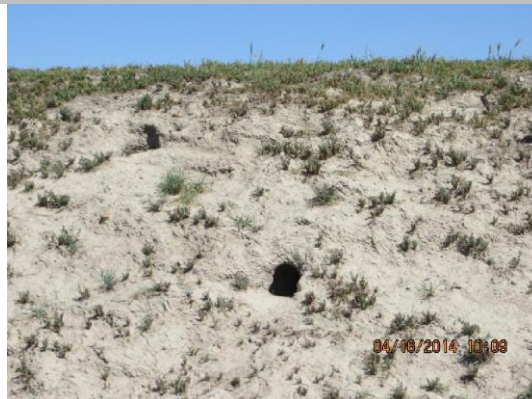
Photo 3 of 3 : UCIP\_SP\_2021\_62051\_61095.jpg

Animal burrows along alignment on LS slope.

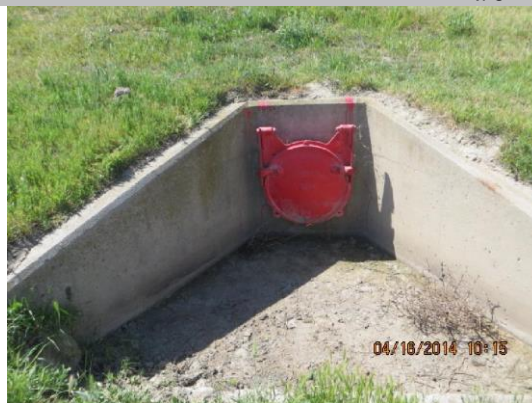
Photo 1 of 3 : UCIP\_SP\_2021\_62052\_61098.jpg

Comment Code						
Inspector Comment						
FS_ID:62052 DS_ID:19835 EP_NO: N/A Repair Type: Non-Urgent Crossing Status: Found UCIP Comments: 04/16/2014 Non-functional landward inlet is buried in sediment. Need to contact owner to determine status. (W. Wylie - DWR UCIP) FIELD_STRUCT_DESC: 24-inch corrugated metal gravity drainage pipe through the levee, 12 feet below the crown. Flap gate on the waterside (WS) end. Concrete headwall on each end. [Additional Reference(s): DWR Levee Log, 2002 (HLM 2.04), listed as a 24-inch corrugated metal pipe (CMP). USACE San Joaquin O&M Manual, Unit 601 Part 1 (SJR601.1), 1967, (HLM 2.05), listed as a 24-inch CMP]. FS Date: 4/16/2014

Pipe, headwall, and flapgate on Ws toe.

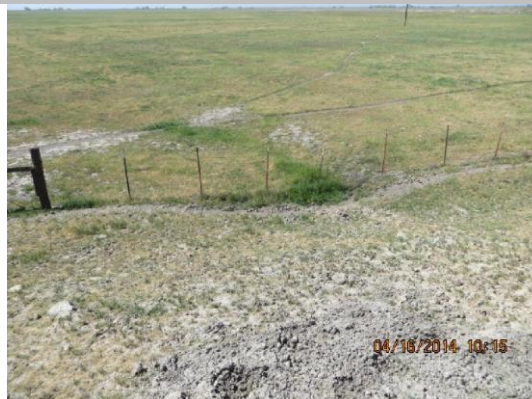
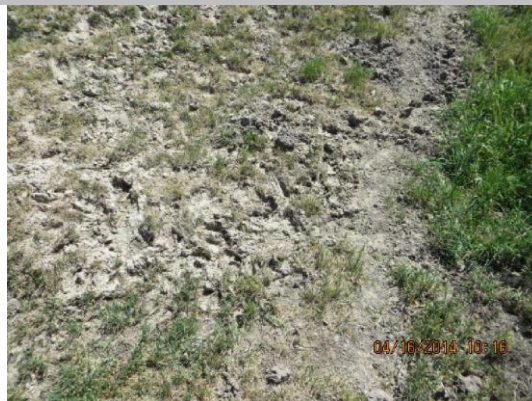
Pipe and headwall buried in sediment at LS toe.
