# Flood Control Project Maintenance Levee Inspections LMA District Cover Sheet

## Lower San Joaquin Levee District

**Flood Control Project Maintenance  
Levee Inspections  
Unit Cover Sheet**

Waterway			Bank	Unit Miles
Unit No. 01 San Joaquin River			Right	22.52
	Spring (March - May)	Summer (June - August)	(September - November) Fall	Winter (December - February)
Unit Maintenance Rating (Fall Only)				
Date of Inspection	5/4/2021 - 5/4/2021			
DWR Inspector	Corey Fujitani			
Accompanied By

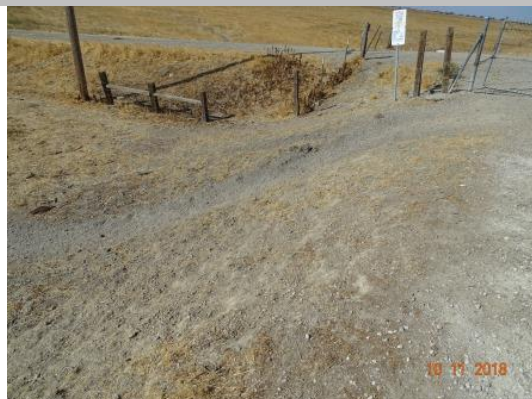
Photo 1 of 1 : SP\_2021\_NA0010\_126\_22\_20210308\_00006.jpg

LM Start	2.07	Rating **	M	Issue No.	22
LM End	2.07	Issue Type +	Ma	Location *	LS
Category	Earthen Levee			GPS Latitude/Longitude	
				Start	End
Item	Animal Control			37.258076 °	37.258076 °
				-120.742439 °	-120.742439 °
DWR ID	DWR_NA0010_08_f_2018_22				
Comment Code					
A2 : Repair the levee slope damaged by livestock and prevent large animal access.					
Inspector Comment					
There is damage to the slope and shoulder from livestock.

Slope and shoulder damage from livestock. (Fall 2018)

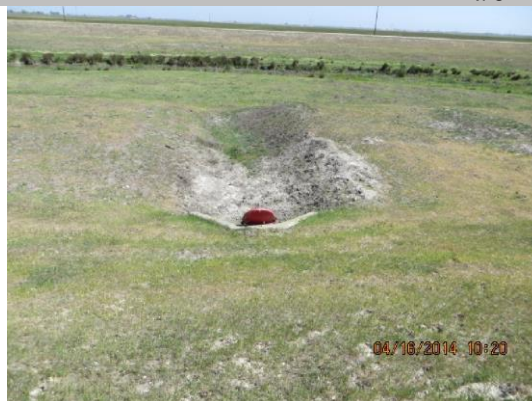
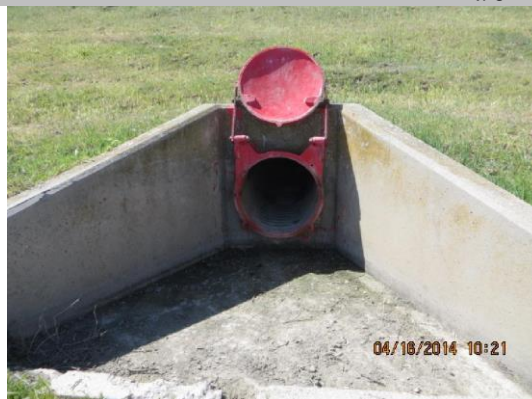
LM Start	2.12	Rating **	M	Issue No.	12	
LM End	2.12	Issue Type +	Ma	Location *		
Category	Supplemental			GPS Latitude/Longitude		
				Start		End
Item	DWR UCIP LMA Responsibility			37.257800 °	37.257800 °	
				-120.741604 °	-120.741604 °	
DWR ID	19836					
Comment Code						
Inspector Comment						
FS_ID:62053 DS_ID:19836 EP_NO: N/A Repair Type: Non-Urgent Crossing Status: Found UCIP Comments: 04/16/2014 Sediment buildup in pipe visible from landward side. (W. Wylie - DWR UCIP) FIELD_STRUCT_DESC: 24-inch corrugated metal gravity drainage pipe through the levee, 9.5 feet below the crown. Flap gate on the waterside (WS) end. Concrete headwall on each end. [Additional Reference(s): DWR Levee Log, 2002 (HLM 2.12), listed as a 24-inch corrugated metal pipe (CMP). USACE San Joaquin O&M Manual, Unit 601 Part 1 (SJR601.1), 1967, (HLM 2.12), listed as a 24-inch CMP]. FS Date: 4/16/2014

Pipe, headwall, and flapgate on WS toe.

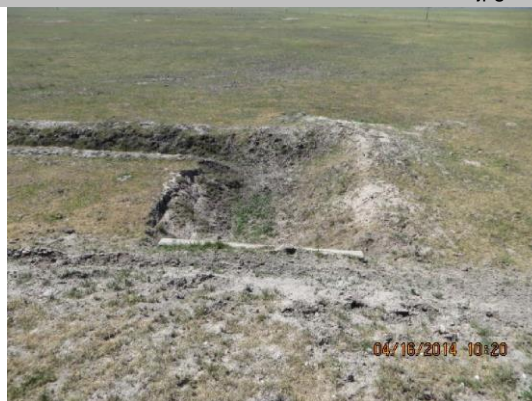
Photo 3 of 3 : UCIP\_SP\_2021\_62053\_61101.jpg

Pipe and headwall on LS toe.

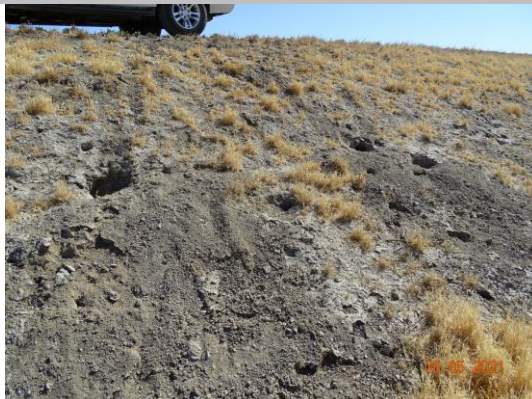
Photo 1 of 1 : SP\_2021\_NA0010\_126\_18\_20210518\_00047.jpg

LM Start	2.43	Rating **	M	Issue No.	18
LM End	2.43	Issue Type +	Ma	Location *	LS
Category	Earthen Levee			GPS Latitude/Longitude	
				Start	End
Item	Animal Control			37.254767 °	37.254767 °
				-120.737772 °	-120.737772 °
DWR ID	DWR_NA0010_08_s_2021_18				
Comment Code					
A1 : Exterminate rodents and backfill and compact or grout burrows.					
Inspector Comment

View of rodent holes in the landside slope. (Spring 2021)

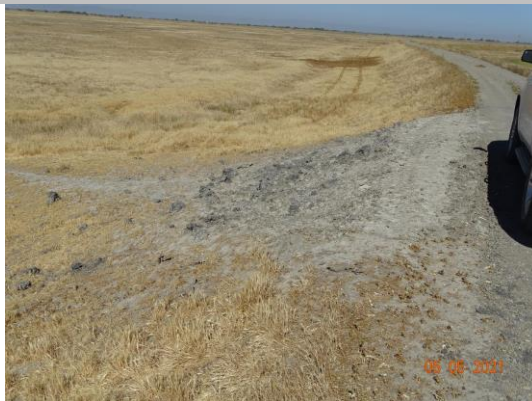
Photo 1 of 1 : SP\_2021\_NA0010\_126\_20\_20210518\_00048.jpg

LM Start	2.74	Rating **	A/W	Issue No.	20
LM End	2.74	Issue Type +	Ma	Location *	LS
Category	Earthen Levee			GPS Latitude/Longitude	
				Start	End
Item	Animal Control			37.252503 °	37.252503 °
				-120.733282 °	-120.733282 °
DWR ID	DWR_NA0010_08_f _ 2018_20				
Comment Code					
A2 : Repair the levee slope damaged by livestock and prevent large animal access.					
Inspector Comment					
Erosion has been repaired. Monitor for settlement.

View of repaired slope damage. (Spring 2021)

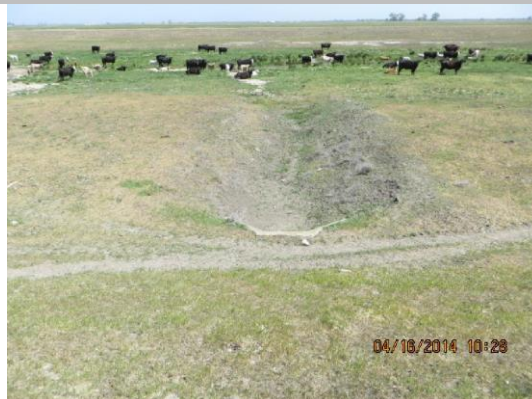
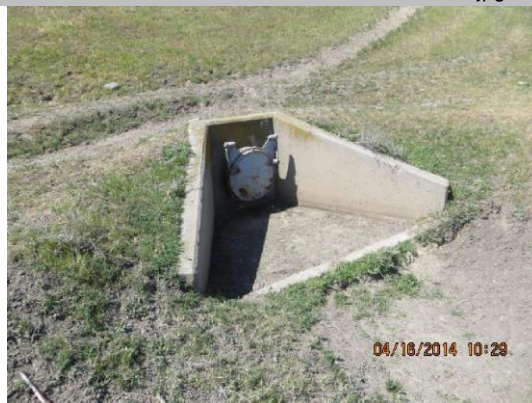
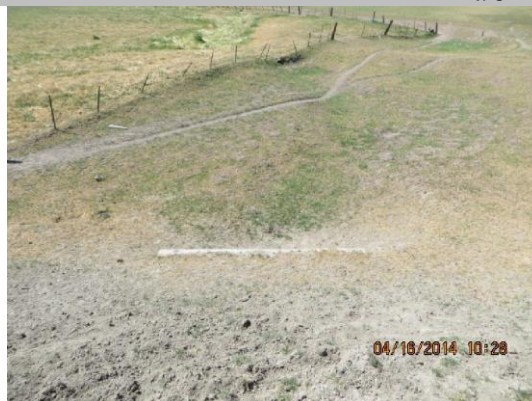
LM Start	2.77	Rating **	A/W	Issue No.	13
LM End	2.77	Issue Type +	Ma	Location *	
Category	Supplemental			GPS Latitude/Longitude	
				Start	End
Item	DWR UCIP LMA Responsibility			37.252228 °	37.252228 °
				-120.732890 °	-120.732890 °
DWR ID	19837				
Comment Code					
Inspector Comment					
FS_ID:62054 DS_ID:19837 EP_NO: N/A Repair Type: No Action Needed Crossing Status: Found UCIP Comments: FIELD_STRUCT_DESC: 24-inch corrugated metal gravity drainage pipe through the levee, 10.5 feet below the crown. Flap gate on the waterside (WS) end. Concrete headwall on each end. [Additional Reference(s): DWR Levee Log, 2002 (HLM 2.77), listed as a 24-inch corrugated metal pipe (CMP). USACE San Joaquin O&M Manual, Unit 601 Part 1 (SJR601.1), 1967, (HLM 2.77), listed as a 24-inch CMP]. FS Date: 4/16/2014

Pipe, headwall, and flapgate on Ws toe.

Pipe and headwall on LS toe.

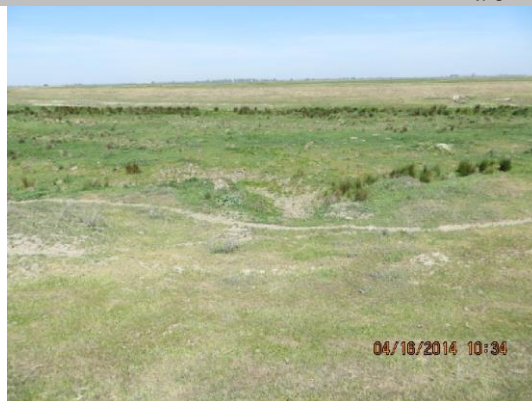
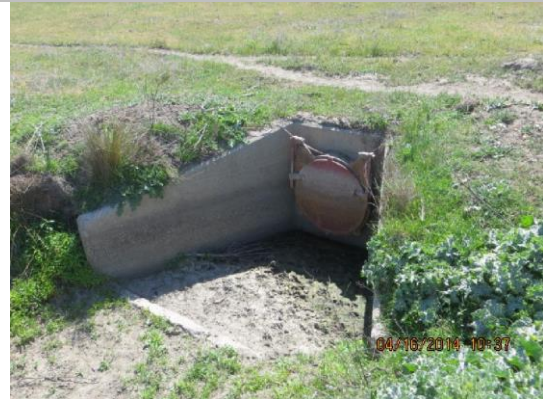
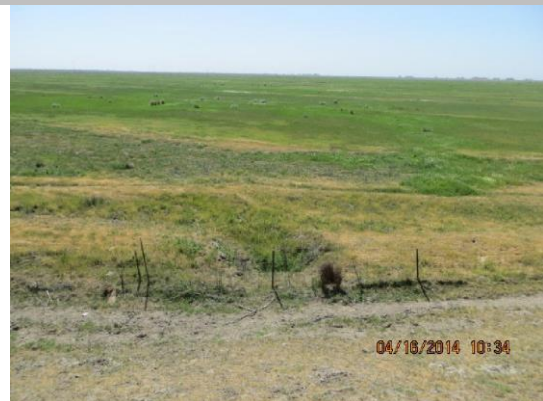
FS\_ID:62058  
 DS\_ID:19838  
 EP\_NO: N/A  
 Repair Type: Non-Urgent  
 Crossing Status: Found  
 UCIP Comments: 7/20/2016 LS inlet buried under dense vegetation. Dense vegetation limits the inspector's visibility to identify signs of pipe failure (leaks) along the WS and LS slope. Recommend removing vegetation along pipe alignment to conduct proper inspection of structure and appurtenances. (O. Magana - DWR UCIP)4/16/2014 Pipe blocked by silt on LS toe. Flapgate rusty and does not operate correctly. (W. Wylie - DWR UCIP)  
 FIELD\_STRUCT\_DESC: 36-inch corrugated metal gravity drainage pipe through the levee, 13.4 feet below the crown. Flap gate on the waterside (WS) end. Concrete headwall on each end. [Additional Reference(s): DWR Levee Log, 2002 (HLM 3.06), listed as a 36-inch corrugated metal pipe (CMP). USACE San Joaquin O&M Manual, Unit 601 Part 1 (SJR601.1), 1967, (HLM 3.06), listed as a 36-inch CMP].

Pipe, headwall, and flapgate on WS toe.

Pipe and headwall on LS toe.

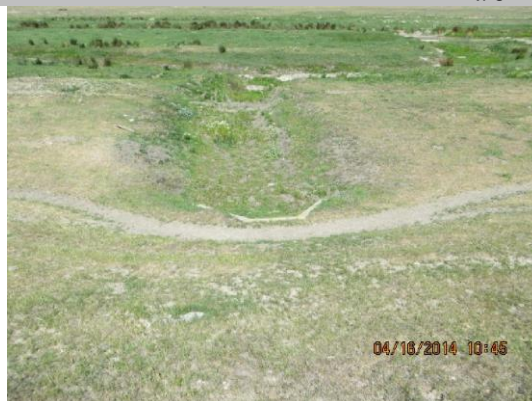
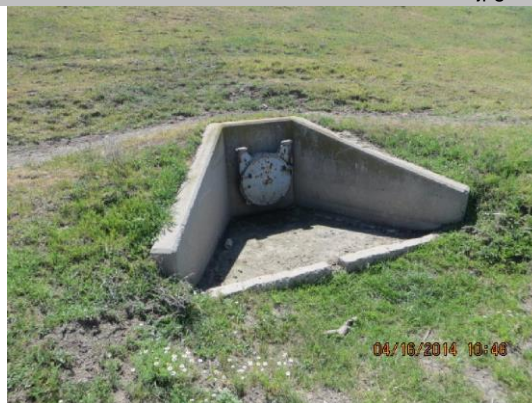
LM Start	3.24	Rating **	A/W	Issue No.	16	
LM End	3.24	Issue Type +	Ma	Location *		
Category	Supplemental			GPS Latitude/Longitude		
				Start		End
Item	DWR UCIP LMA Responsibility			37.252230 °		37.252230 °
				-120.725504 °		-120.725504 °
DWR ID	19839					
Comment Code						
Inspector Comment						
FS_ID:62056 DS_ID:19839 EP_NO: N/A Repair Type: No Action Needed Crossing Status: Found UCIP Comments: FIELD_STRUCT_DESC: 24-inch corrugated metal gravity drainage pipe through the levee, 10 feet below the crown. Flap gate on the waterside (WS) end. Concrete headwall on each end. [Additional Reference(s): DWR Levee Log, 2002 (HLM 3.23), listed as a 24-inch corrugated metal pipe (CMP). USACE San Joaquin O&M Manual, Unit 601 Part 1 (SJR601.1), 1967, (HLM 3.24), listed as a 24-inch CMP]. FS Date: 4/16/2014

Pipe, flapgate, and headwall on WS toe.

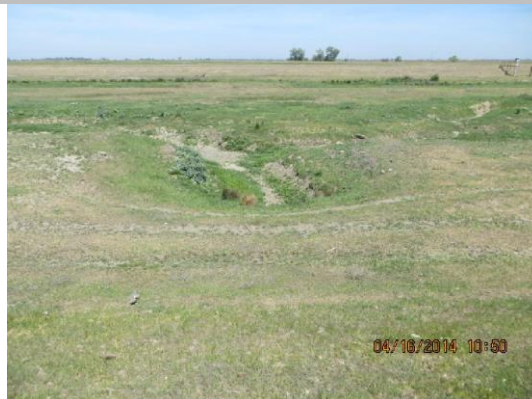
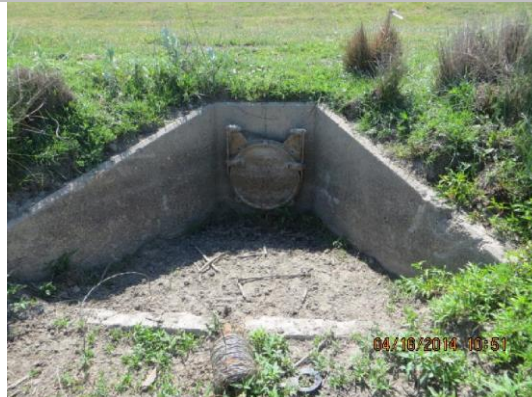
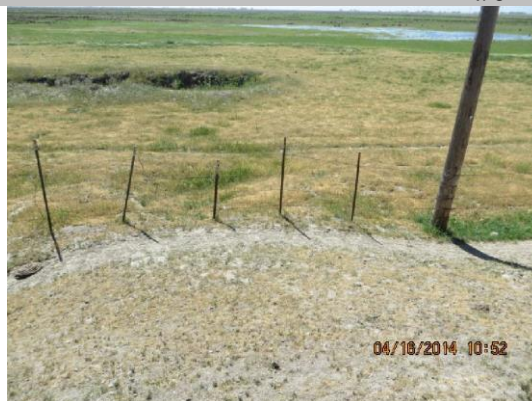
Comment Code						
Inspector Comment						
FS_ID:62057 DS_ID:19840 EP_NO: N/A Repair Type: Non-Urgent Crossing Status: Found UCIP Comments: 04/16/2014 No access available on landward side. Need to confirm status of crossing. (W. Wylie - DWR UCIP) FIELD_STRUCT_DESC: 24-inch corrugated metal gravity drainage pipe through the levee, 13 feet below the crown. Flap gate on the waterside (WS) end. Concrete headwall on each end. [Additional Reference(s): DWR Levee Log, 2002 (HLM 3.43), listed as a 24-inch corrugated metal pipe (CMP). USACE San Joaquin O&M Manual, Unit 601 Part 1 (SJR601.1), 1967, (HLM 3.43), listed as a 24-inch CMP]. FS Date: 4/16/2014

Pipe, headwall, and flapgate on WS toe.

Pipe likely at drainage swale off LS toe.

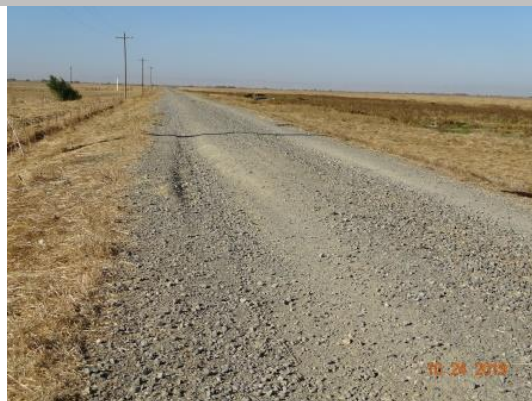
Photo 1 of 1 : SP\_2021\_NA0010\_126\_19\_20210308\_00004.jpg

LM Start	3.49	Rating **	M	Issue No.	19
LM End	3.49	Issue Type +	Ma	Location *	CR
Category	Earthen Levee			GPS Latitude/Longitude	
				Start	End
Item	Crown Surface / Depressions / Rutting			37.253403 °	37.253403 °
				-120.721095 °	-120.721095 °
DWR ID	DWR_NA0010_08_f_2018_19				
Comment Code					
C2 : Repair depressions or ruts in the crown or slope.					
Inspector Comment

View of ruts forming in the levee crown. (Fall 2019)

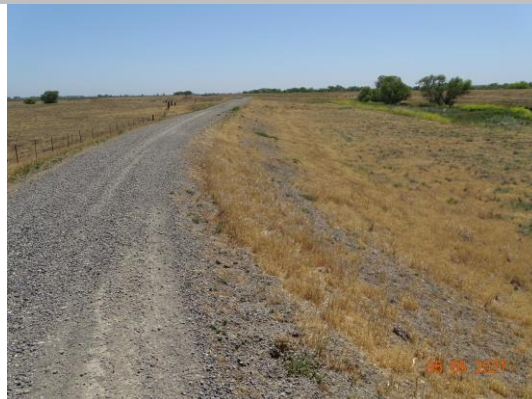
Photo 1 of 1 : SP\_2021\_NA0010\_127\_5\_20210518\_00011.jpg

LM Start	0.22	Rating **	A	Issue No.	5
LM End	0.22	Issue Type +	Ma	Location *	WS
Category	Earthen Levee			GPS Latitude/Longitude	
				Start	End
Item	Vegetation			37.219975 °	37.219975 °
				-120.709616 °	-120.709616 °
DWR ID	DWR_NA0010_09_s_2021_5				
Comment Code					
V1 : Control annual grass and weeds on the levee slopes and easements.					
Inspector Comment					
The annual vegetation is well maintained.

View of vegetation management on the waterside slope. (Spring 2021)

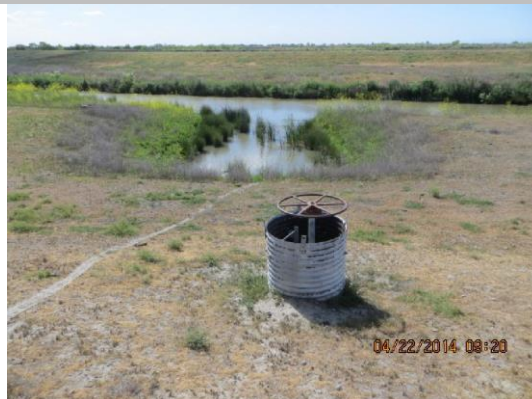
Photo 1 of 3 : UCIP\_SP\_2021\_62059\_62119.jpg

Comment Code						
Inspector Comment						
FS_ID:62059 DS_ID:19841 EP_NO: N/A Repair Type: Non-Urgent Crossing Status: Found UCIP Comments: 04/22/2014 Concrete headwalls on landward and waterward under water. Need photo to confirm condition of concrete headwalls, pipe, and gate on both toes. (W. Wylie - DWR UCIP) FIELD_STRUCT_DESC: 24-inch corrugated metal gravity drainage pipe through the levee, 18.7 feet below the crown. Slide gate in a 36-inch corrugated metal pipe (CMP) riser on the waterside (WS) slope. Concrete U-shaped headwall on each end. [Additional Reference(s): DWR Levee Log, 2002 (HLM 0.48), listed as a 24-inch corrugated metal pipe (CMP). USACE San Joaquin O&M Manual, Unit 601 Part 1 (SJR601.1), 1967, (HLM 0.47), listed as a 24-inch CMP]. FS Date: 4/22/2014

Slide gate in CMP riser on WS slope with outlet visible in background.

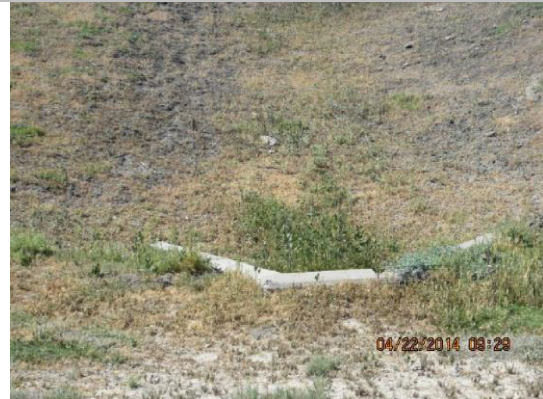
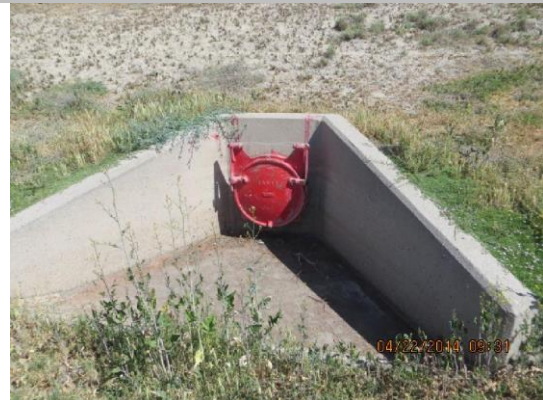
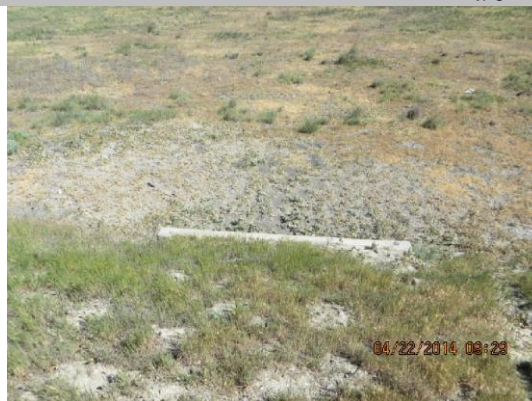
Comment Code						
Inspector Comment						
FS_ID:62060						
DS_ID:19842						
EP_NO: N/A						
Repair Type: Non-Urgent						
Crossing Status: Found						
UCIP Comments: 04/22/2014 Animal burrows in area on LS slope.						
Minor sediment buildup in pipe visible on landward side--recommend						
clearing. (W. Wylie - DWR UCIP)						
FIELD_STRUCT_DESC: 24-inch corrugated metal gravity drainage						
pipe through the levee, 8.7 feet below the crown. Flap gate on the						
waterside (WS) end. Concrete headwall on the landside (LS) end.						
Concrete U-shaped headwall on the WS end. [Additional Reference(s):						
DWR Levee Log, 2002 (HLM 0.70), listed as a 24-inch corrugated metal						
pipe (CMP). USACE San Joaquin O&M Manual, Unit 601 Part 1						
(SJR601.1), 1967, (HLM 0.70), listed as a 24-inch CMP].						
FS Date: 4/22/2014

Headwall, flapgate, and pipe on WS toe.

Headwall and pipe on LS toe.

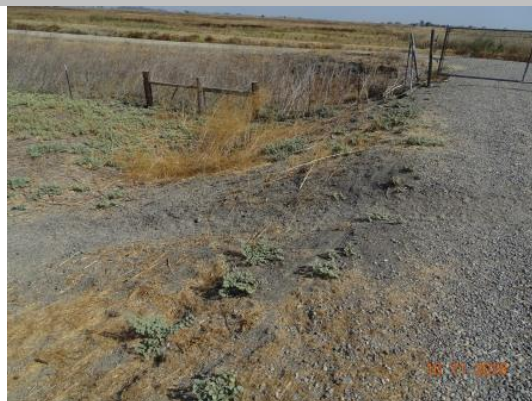
Photo 1 of 1 : SP\_2021\_NA0010\_127\_4\_20210308\_00001.jpg

LM Start	0.86	Rating **	A/W	Issue No.	4
LM End	0.86	Issue Type +	Ma	Location *	LS
Category	Earthen Levee			GPS Latitude/Longitude	
				Start	End
Item	Animal Control			37.220041 °	37.220041 °
				-120.698425 °	-120.698425 °
DWR ID	DWR_NA0010_09_f_2017_4				
Comment Code					
A2 : Repair the levee slope damaged by livestock and prevent large animal access.					
Inspector Comment					
Material has been placed over erosion site. Monitor for settlement.

View of slope erosion due to foot traffic. (Fall 2018)

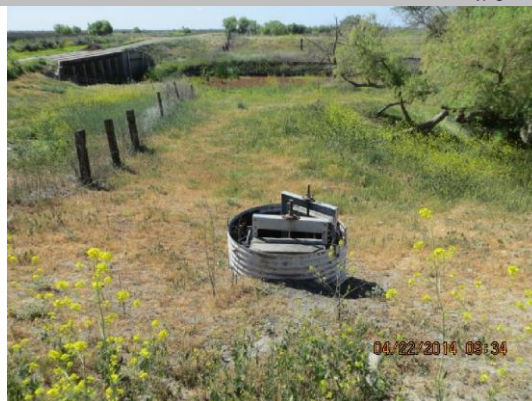
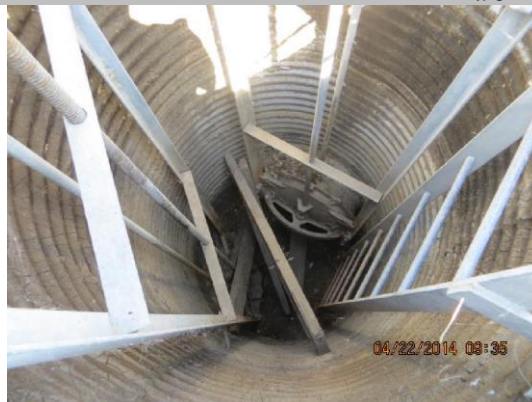
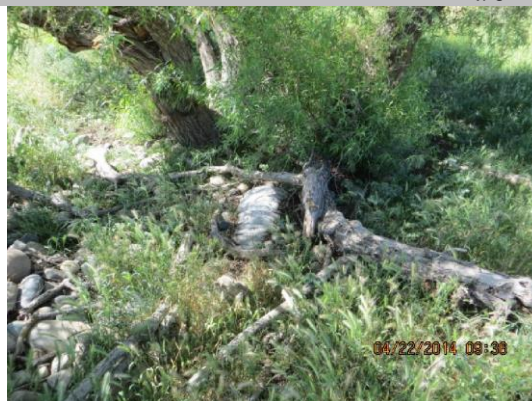
Comment Code						
Inspector Comment						
FS_ID:62061						
DS_ID:19843						
EP_NO: N/A						
Repair Type: No Action Needed						
Crossing Status: Found						
UCIP Comments:						
FIELD_STRUCT_DESC: [Crane Irrigation Structure] 24-inch corrugated metal gravity drainage pipe through the levee, 9.7 feet below the crown. Two slide gates in a 48-inch corrugated metal pipe (CMP) riser on the waterside (WS) slope. Concrete U-shaped headwall on the landside (LS) end. WS end cobble revetted on the bank and in the outlet drain. [Additional Reference(s): DWR Levee Log, 2002 (HLM 0.87), listed as a 24-inch corrugated metal pipe (CMP). USACE San Joaquin O&M Manual, Unit 601 Part 1 (SJR601.1), 1967, (HLM 0.87), listed as a 24-inch CMP].						
FS Date: 4/22/2014

48-inch CMP riser with slide gates on WS slope.

Inside CMP riser on WS slope.

Outlet at WS toe.

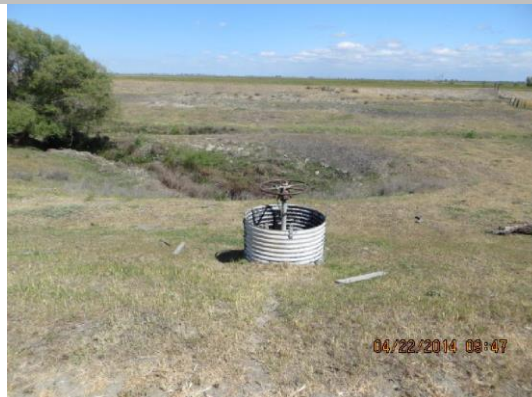
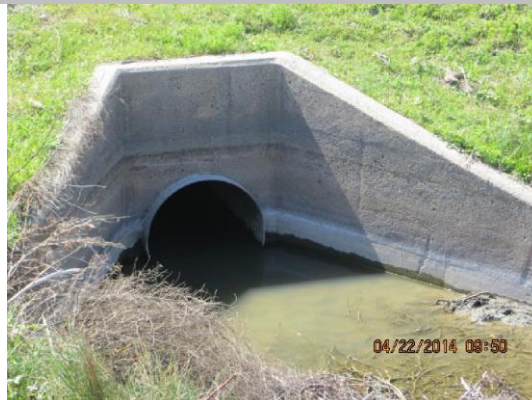
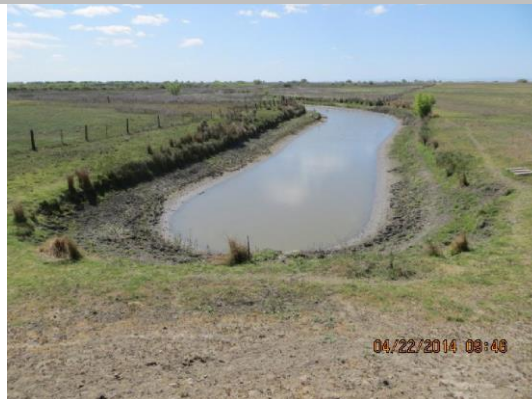
FS\_ID:62062  
DS\_ID:19845  
EP\_NO: N/A  
Repair Type: Non-Urgent  
Crossing Status: Found  
UCIP Comments: 04/22/2014 Inlet blocked at LS toe by wooden gate.  
Need to contact owner to determine status. (W. Wylie - DWR UCIP)  
FIELD\_STRUCT\_DESC: 36-inch corrugated metal gravity drainage pipe through the levee, 19.6 feet below the crown. Slide gate in a 48-inch corrugated metal pipe (CMP) riser on the waterside (WS) slope. Concrete U-shaped headwall on each end. [Additional Reference(s): DWR Levee Log, 2002 (HLM 0.31), listed as a 24-inch corrugated metal pipe (CMP). USACE San Joaquin O&M Manual, Unit 601 Part 1 (SJR601.1), 1967, (HLM 0.31), listed as a 24-inch CMP].  
FS Date: 4/22/2014

Headwall and pipe visible on LS toe. Slide gate inside 48-inch CMP riser on WS slope.

Headwall and pipe on WS toe.

Headwall and pipe on LS toe. Pipe blocked by wooden cover.

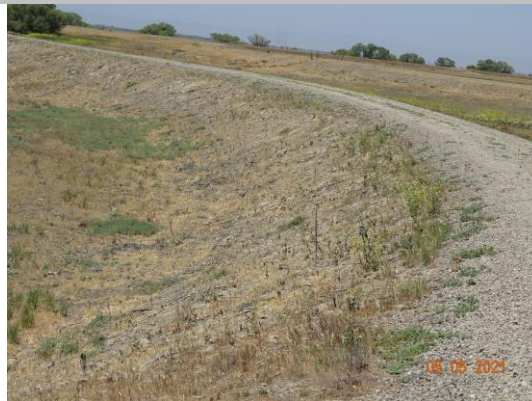
Photo 1 of 1 : SP\_2021\_NA0010\_128\_2\_20210518\_00004.jpg

LM Start	0.46	Rating **	A	Issue No.	2
LM End	0.46	Issue Type +	Ma	Location *	LS
Category	Earthen Levee			GPS Latitude/Longitude	
				Start	End
Item	Vegetation			37.219613 °	37.219613 °
				-120.703765 °	-120.703765 °
DWR ID	DWR_NA0010_10_s_2021_2				
Comment Code					
V1 : Control annual grass and weeds on the levee slopes and easements.					
Inspector Comment					
The annual vegetation is well maintained.

View of vegetation management on the landside slope. (Spring 2021)

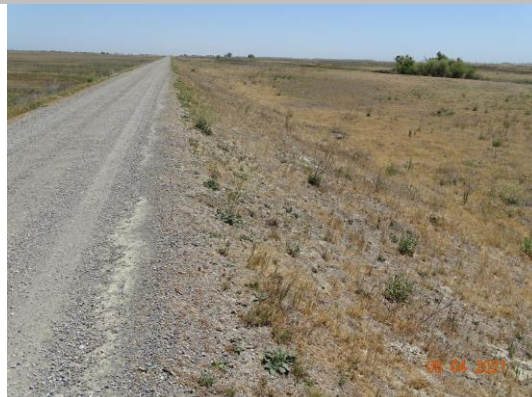
Photo 1 of 1 : SP\_2021\_NA0010\_129\_14\_20210518\_00030.jpg

LM Start	0.02	Rating **	A	Issue No.	14
LM End	0.02	Issue Type +	Ma	Location *	WS
Category	Earthen Levee			GPS Latitude/Longitude	
				Start	End
Item	Vegetation			37.202739 °	37.202739 °
				-120.754827 °	-120.754827 °
DWR ID	DWR_NA0010_11_s_2021_14				
Comment Code					
V1 : Control annual grass and weeds on the levee slopes and easements.					
Inspector Comment					
The annual vegetation is well maintained.

Looking upstream along the waterside slope. (Spring 2021)

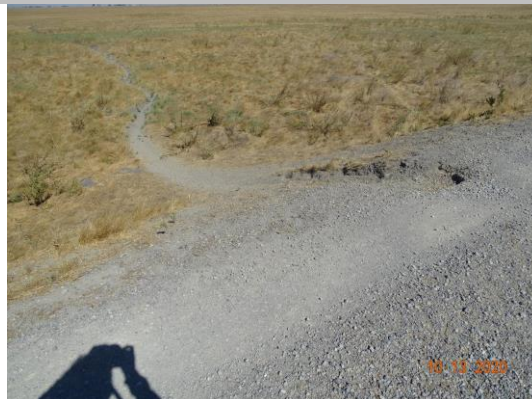
Photo 1 of 1 : SP\_2021\_NA0010\_129\_10\_20210308\_00002.jpg

LM Start	0.16	Rating **	A/W	Issue No.	10
LM End	0.16	Issue Type +	Ma	Location *	LS
Category	Earthen Levee			GPS Latitude/Longitude	
				Start	End
Item	Animal Control			37.202730 °	37.202730 °
				-120.752270 °	-120.752270 °
DWR ID	DWR_NA0010_11_f _ 2018_10				
Comment Code					
A2 : Repair the levee slope damaged by livestock and prevent large animal access.					
Inspector Comment					
Material has been placed on levee damage. Monitor for settlement.

View of livestock damage to the landside slope. (Fall 2020)

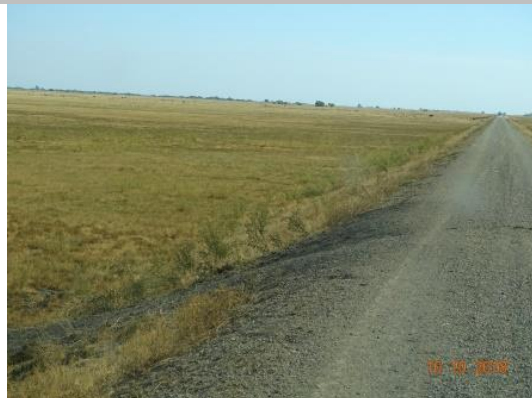
Photo 1 of 1 : SP\_2021\_NA0010\_129\_11\_20210308\_00003.jpg

LM Start	0.21	Rating **	A/W	Issue No.	11
LM End	0.21	Issue Type +	Ma	Location *	LS
Category	Earthen Levee			GPS Latitude/Longitude	
				Start	End
Item	Animal Control			37.202731 °	37.202731 °
				-120.751389 °	-120.751389 °
DWR ID	DWR_NA0010_11_f_2018_11				
Comment Code					
A2 : Repair the levee slope damaged by livestock and prevent large animal access.					
Inspector Comment					
Material has been placed on levee damage. Monitor for settlement.

View of slope damage on landside. (Fall 2018)

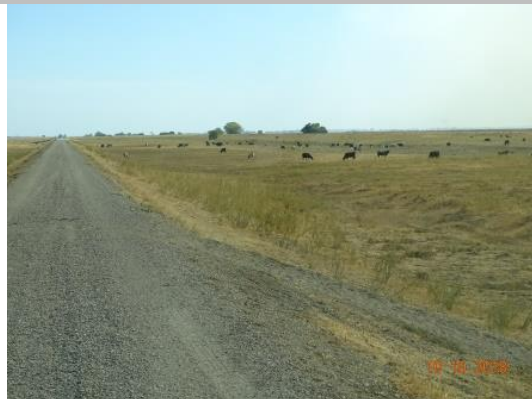
Photo 1 of 1 : SP\_2021\_NA0010\_129\_13\_20210308\_00006.jpg

LM Start	0.21	Rating **	A/W	Issue No.	13
LM End	0.21	Issue Type +	Ma	Location *	WS
Category	Earthen Levee			GPS Latitude/Longitude	
				Start	End
Item	Animal Control			37.202731 °	37.202731 °
				-120.751389 °	-120.751389 °
DWR ID	DWR_NA0010_11_s_2020_13				
Comment Code					
A2 : Repair the levee slope damaged by livestock and prevent large animal access.					
Inspector Comment					
Material has been placed on levee damage. Monitor for settlement.

View of damage on waterside shoulder and slope. (Fall 2018)

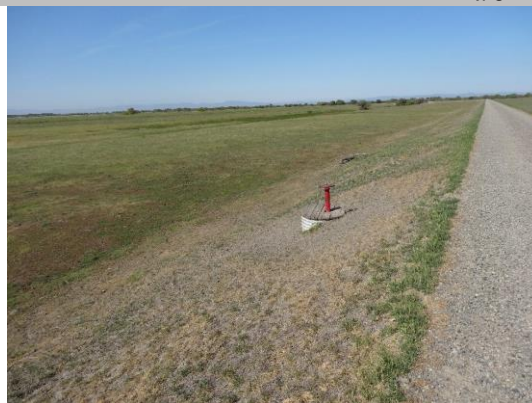
Photo 1 of 3 : UCIP\_SP\_2021\_62063\_66644.jpg

Comment Code						
Inspector Comment						
FS_ID:62063 DS_ID:19846 EP_NO: N/A Repair Type: Non-Urgent Crossing Status: Found UCIP Comments: 04/18/2014 Need to contact owner. Recommend clearing sediment deposit inside pipe. (O. Magana - DWR UCIP) FIELD_STRUCT_DESC: 24-inch corrugated metal gravity drainage pipe through the levee, 11 feet below the crown. Slide gate in a corrugated metal pipe (CMP) riser on the waterside (WS) end. [Additional Reference(s): DWR Levee Log, 2002 (HLM 0.43), listed as a 24-inch corrugated metal pipe (CMP). USACE San Joaquin O&M Manual, Unit 601 Part 1 (SJR601.1), 1967, (HLM 0.42), listed as a 24-inch CMP]. FS Date: 4/18/2014

View of slide gate inside CMP riser located on waterward slope.

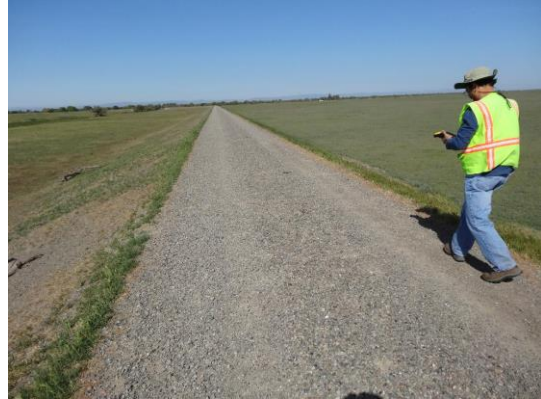
Photo 2 of 3 : UCIP\_SP\_2021\_62063\_66643.jpg

View of levee crown at crossing.

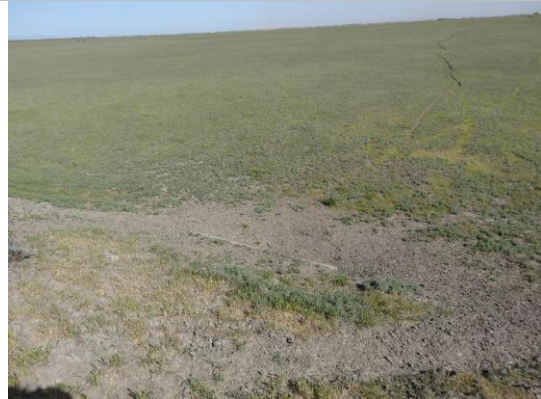
Photo 3 of 3 : UCIP\_SP\_2021\_62063\_66642.jpg

View of landward side.

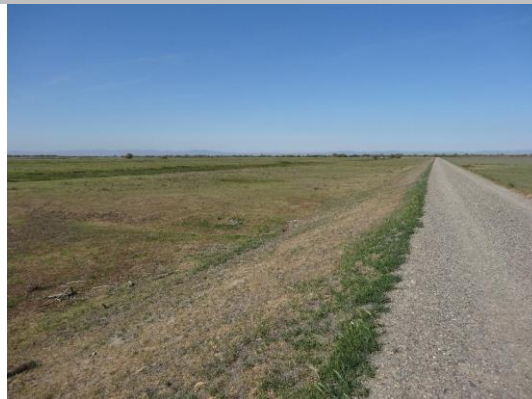
Photo 1 of 3 : UCIP\_SP\_2021\_62064\_61997.jpg

Comment Code						
Inspector Comment						
FS_ID:62064						
DS_ID:19847						
EP_NO: N/A						
Repair Type: Non-Urgent						
Crossing Status: Found						
UCIP Comments: 04/18/2014 Need to contact owner. Recommend clearing sediment deposit inside pipe. (O. Magana - DWR UCIP)						
FIELD_STRUCT_DESC: 24-inch corrugated metal gravity drainage pipe through the levee, 10 feet below the crown. Flap gate on the waterside (WS) end. [Additional Reference(s): DWR Levee Log, 2002 (HLM 0.65), listed as a 24-inch corrugated metal pipe (CMP). USACE San Joaquin O&M Manual, Unit 601 Part 1 (SJR601.1), 1967, (HLM 0.65), listed as a 24-inch CMP].						
FS Date: 4/18/2014

View of waterward side.

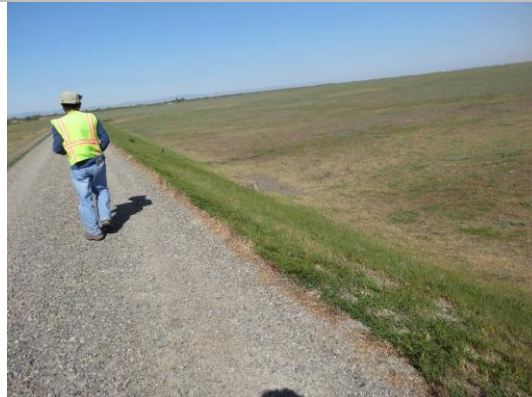
Photo 2 of 3 : UCIP\_SP\_2021\_62064\_61996.jpg

View of landward side.

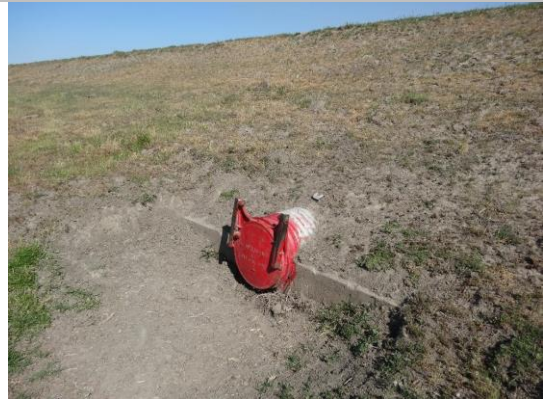
Photo 2 of 3 : UCIP\_SP\_2021\_62065\_62002.jpg

Concrete headwall and flap gate visible on waterward side.

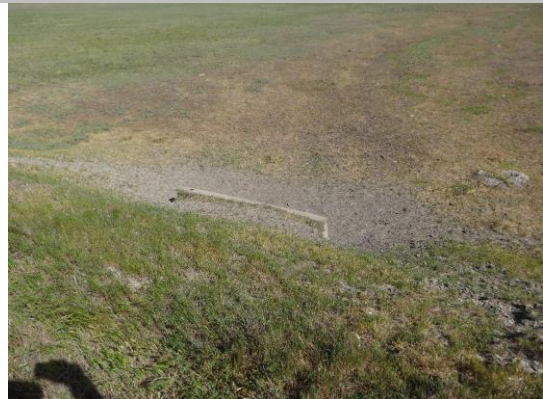
Photo 3 of 3 : UCIP\_SP\_2021\_62065\_62001.jpg

View of landward side.

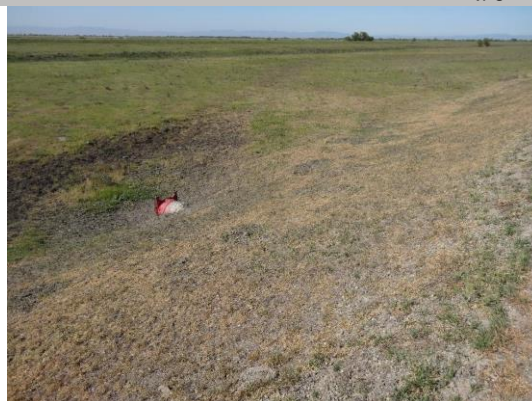
Photo 1 of 3 : UCIP\_SP\_2021\_62066\_62008.jpg

Comment Code						
Inspector Comment						
FS_ID:62066						
DS_ID:19849						
EP_NO: N/A						
Repair Type: Non-Urgent						
Crossing Status: Found						
UCIP Comments: 04/18/2014 Need to contact owner. Recommend clearing sediment deposit inside pipe. (O. Magana - DWR UCIP)						
FIELD_STRUCT_DESC: 24-inch corrugated metal gravity drainage pipe through the levee, 9 feet below the crown. Flap gate on the waterside (WS) end. [Additional Reference(s): DWR Levee Log, 2002 (HLM 1.13), listed as a 24-inch corrugated metal pipe (CMP). USACE San Joaquin O&M Manual, Unit 601 Part 1 (SJR601.1), 1967, (HLM 1.13), listed as a 24-inch CMP].						
FS Date: 4/18/2014

View of waterward side--flap gate visible at levee toe.

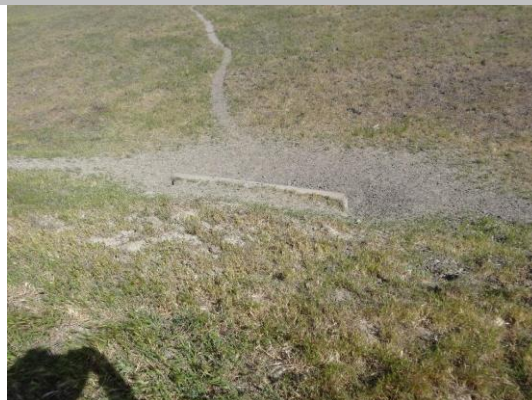
Photo 2 of 3 : UCIP\_SP\_2021\_62066\_62007.jpg

View of landward side.

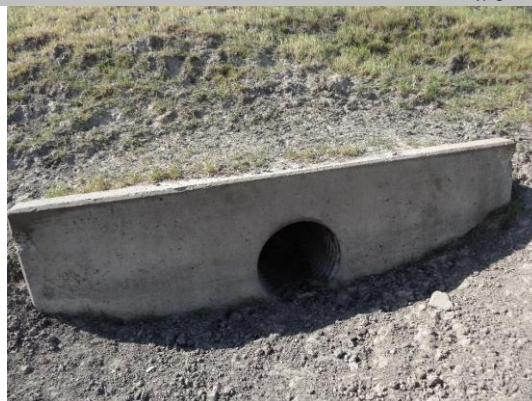
Photo 3 of 3 : UCIP\_SP\_2021\_62066\_62006.jpg

Concrete headwall located on landward side.

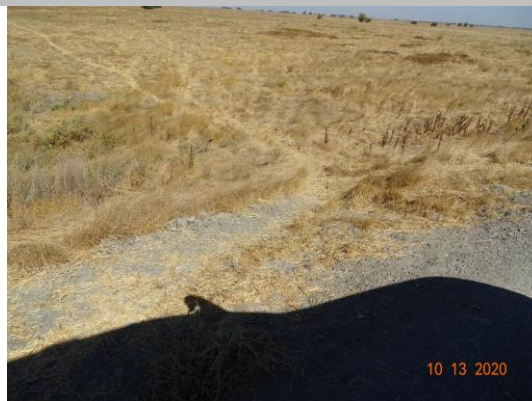
Photo 1 of 1 : SP\_2021\_NA0010\_129\_9\_20210308\_00001.jpg

LM Start	1.49	Rating **	A/W	Issue No.	9
LM End	1.49	Issue Type +	Ma	Location *	LS
Category	Earthen Levee			GPS Latitude/Longitude	
				Start	End
Item	Animal Control			37.202748 °	37.202748 °
				-120.728182 °	-120.728182 °
DWR ID	DWR_NA0010_11_f_2017_9				
Comment Code					
A2 : Repair the levee slope damaged by livestock and prevent large animal access.					
Inspector Comment

View of livestock trail on the landside slope. (Fall 2020)

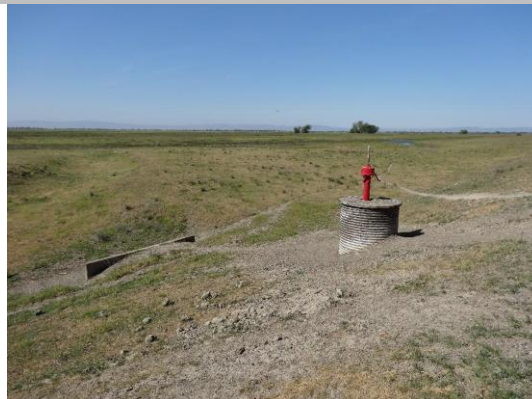
Photo 1 of 3 : UCIP\_SP\_2021\_62067\_62018.jpg

Comment Code						
Inspector Comment						
FS_ID:62067						
DS_ID:19850						
EP_NO: N/A						
Repair Type: Non-Urgent						
Crossing Status: Found						
UCIP Comments: 04/18/2014 Need to contact owner. Recommend clearing sediment deposit inside pipe. (O. Magana - DWR UCIP)						
FIELD_STRUCT_DESC: 48-inch corrugated metal gravity drainage pipe through the levee, 16.3 feet below the crown. Slide gate in a pipe riser on the waterside (WS) slope. [Additional Reference(s): DWR Levee Log, 2002 (HLM 1.50), listed as a 48-inch corrugated metal pipe (CMP). USACE San Joaquin O&M Manual, Unit 601 Part 1 (SJR601.1), 1967, (HLM 1.50), listed as a 48-inch CMP].						
FS Date: 4/18/2014

View of waterward side.

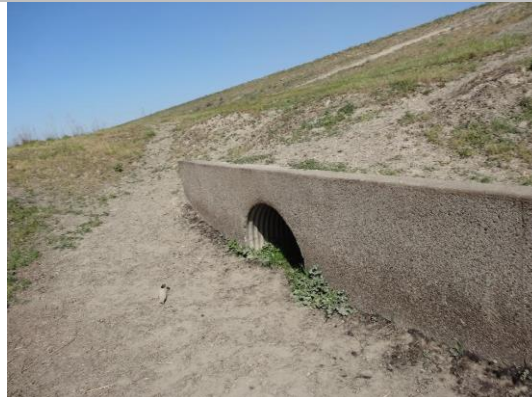
Photo 2 of 3 : UCIP\_SP\_2021\_62067\_62017.jpg

View of concrete headwall located on waterward side.

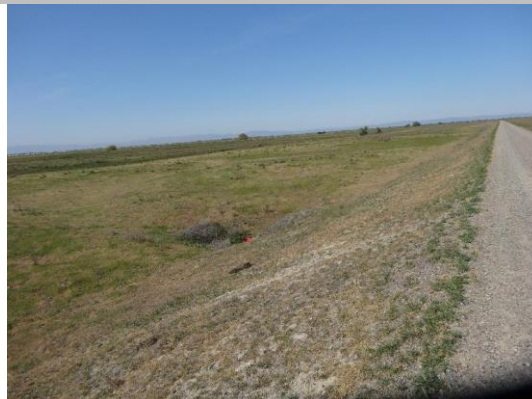
Photo 1 of 3 : UCIP\_SP\_2021\_62068\_62024.jpg

LM Start	1.98	Rating **	M	Issue No.	7	
LM End	1.98	Issue Type +	Ma	Location *		
Category	Supplemental			GPS Latitude/Longitude		
				Start		End
Item	DWR UCIP LMA Responsibility			37.202740 °		37.202740 °
				-120.719247 °		-120.719247 °
DWR ID	19851					
Comment Code						
Inspector Comment						
FS_ID:62068 DS_ID:19851 EP_NO: N/A Repair Type: Non-Urgent Crossing Status: Found UCIP Comments: 04/18/2014 Need to contact owner. Recommend clearing sediment deposit inside pipe. (O. Magana - DWR UCIP) FIELD_STRUCT_DESC: 24-inch corrugated metal gravity drainage pipe through the levee, 12.8 feet below the crown. Flap gate on the waterside (WS) end. [Additional Reference(s): DWR Levee Log, 2002 (HLM 1.99), listed as a 24-inch corrugated metal pipe (CMP). USACE San Joaquin O&M Manual, Unit 601 Part 1 (SJR601.1), 1967, (HLM 1.99), listed as a 24-inch CMP]. FS Date: 4/18/2014

View of waterward side.

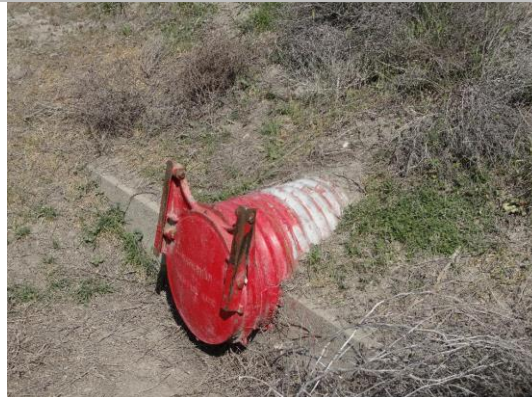
Photo 2 of 3 : UCIP\_SP\_2021\_62068\_62025.jpg

Flap gate located on waterward side.

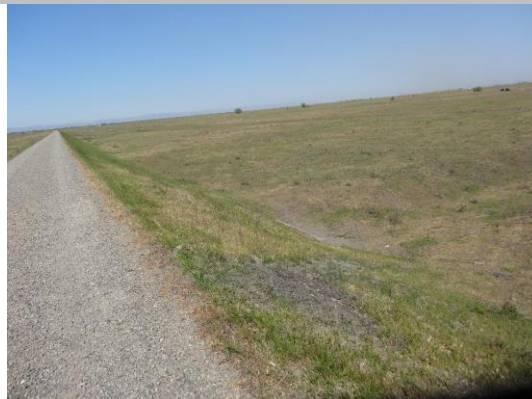
Photo 3 of 3 : UCIP\_SP\_2021\_62068\_62023.jpg

View of landward side.

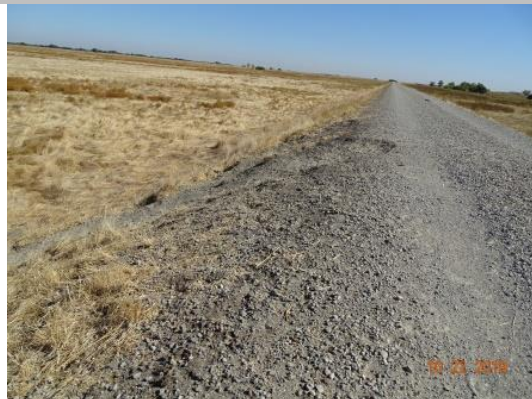
Photo 1 of 1 : SP\_2021\_NA0010\_129\_17\_20210308\_00008.jpg

LM Start	2.31	Rating **	M	Issue No.	17
LM End	2.31	Issue Type +	Ma	Location *	LS
Category	Earthen Levee			GPS Latitude/Longitude	
				Start	End
Item	Animal Control			37.202730 °	37.202730 °
				-120.713368 °	-120.713368 °
DWR ID	DWR_NA0010_11_f_2019_17				
Comment Code					
A2 : Repair the levee slope damaged by livestock and prevent large animal access.					
Inspector Comment

Damage to the landside slope from livestock traffic. (Fall 2019)

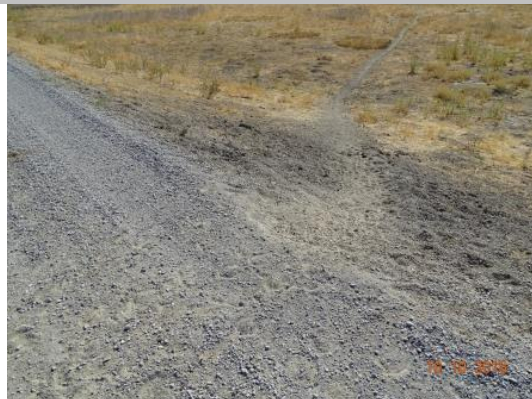
Photo 2 of 2 : SP\_2021\_NA0010\_129\_12\_20210308\_00005.jpg

View of waterside slope. (Fall 2018)

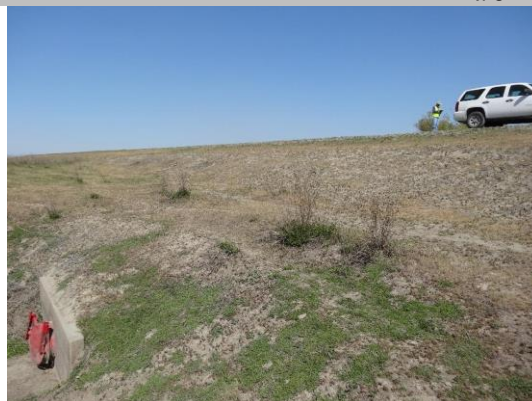
Photo 1 of 3 : UCIP\_SP\_2021\_62069\_62028.jpg

FS\_ID:62069  
 DS\_ID:19852  
 EP\_NO: N/A  
 Repair Type: Non-Urgent  
 Crossing Status: Found  
 UCIP Comments: 04/18/2014 Need to contact owner. Recommend clearing sediment deposit inside pipe. (O. Magana - DWR UCIP)  
 FIELD\_STRUCT\_DESC: 24-inch corrugated metal gravity drainage pipe through the levee, 15 feet below the crown. Flap gate on the waterside (WS) end. [Additional Reference(s): DWR Levee Log, 2002 (HLM 3.04), listed as a 24-inch corrugated metal pipe (CMP). USACE San Joaquin O&M Manual, Unit 601 Part 1 (SJR601.1), 1967, (HLM 3.04), listed as a 24-inch CMP].  
 FS Date: 4/18/2014

Overview of waterward side--flap gate, concrete headwall and apron visible on levee toe.

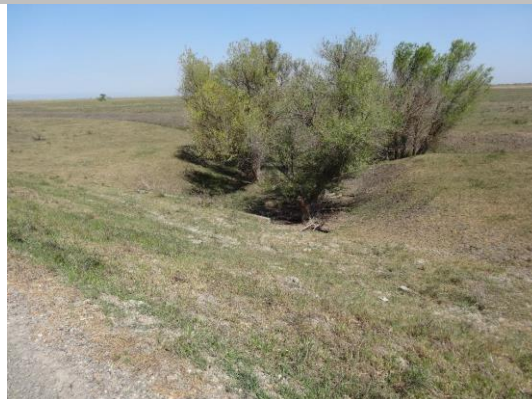
Photo 2 of 3 : UCIP\_SP\_2021\_62069\_62027.jpg

View of landward side.

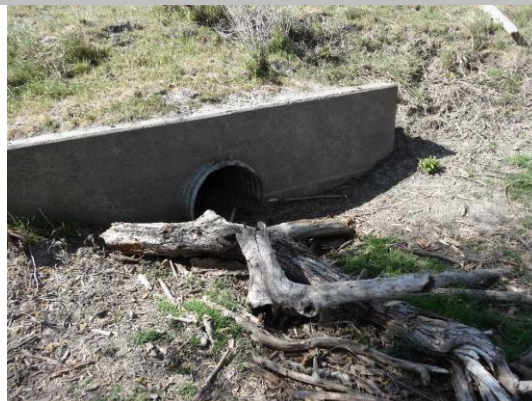
Photo 3 of 3 : UCIP\_SP\_2021\_62069\_62030.jpg

Concrete headwall located on landward side--debris in front of headwall.

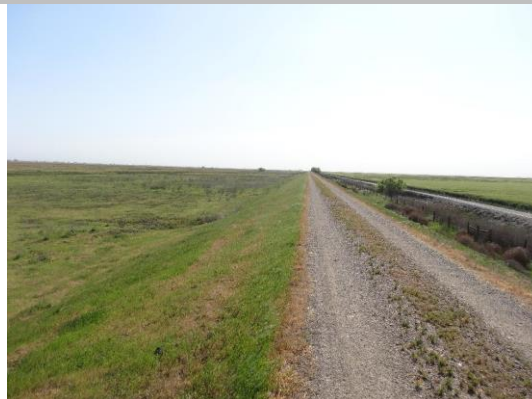
Photo 1 of 3 : UCIP\_SP\_2021\_62072\_66647.jpg

Comment Code						
Inspector Comment						
FS_ID:62072						
DS_ID:19855						
EP_NO: N/A						
Repair Type: Non-Urgent						
Crossing Status: Found						
UCIP Comments: 04/18/2014 Need to contact owner. Dense vegetation limits the inspector's visibility to identify signs of pipe failure (leaks) along the waterward slope. Recommend removing vegetation along pipe alignment to conduct proper inspection of structure. (O. Magana - DWR UCIP)						
FIELD_STRUCT_DESC: 24-inch corrugated metal gravity drainage pipe through the levee, 10.5 feet below the crown. Flap gate on the waterside (WS) end. [Additional Reference(s): DWR Levee Log, 2002 (HLM 0.41), listed as a 24-inch corrugated metal pipe (CMP). USACE San Joaquin O&M Manual, Unit 601 Part 1 (SJR601.1), 1967, (HLM 0.39), listed as a 24-inch CMP].						
FS Date: 4/18/2014

View of waterward side.

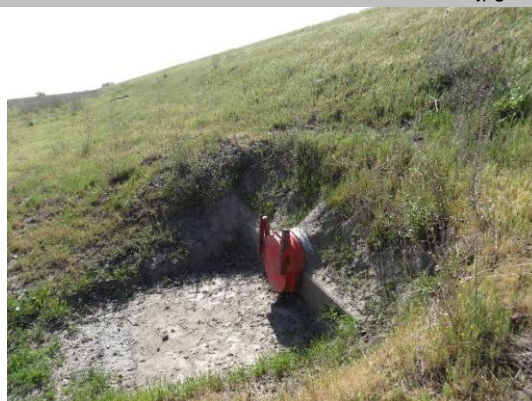
Photo 2 of 3 : UCIP\_SP\_2021\_62072\_66649.jpg

Concrete headwall and flap gate visible on waterward side.

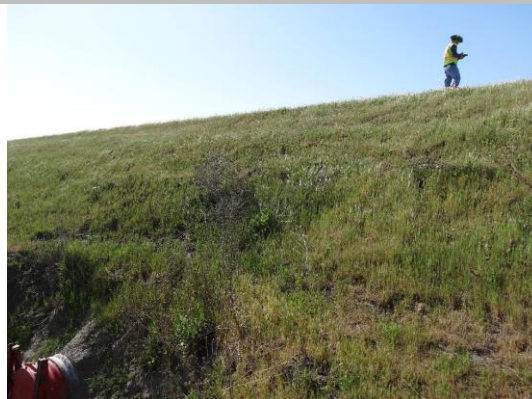
Photo 3 of 3 : UCIP\_SP\_2021\_62072\_66648.jpg

View of waterward side--medium grass throughout slope.

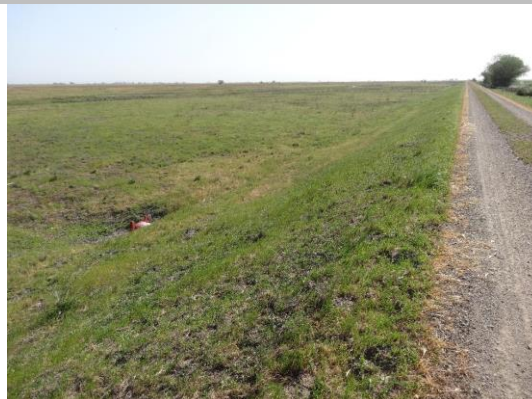
Photo 1 of 3 : UCIP\_SP\_2021\_62073\_62048.jpg

FS\_ID:62073  
 DS\_ID:19856  
 EP\_NO: N/A  
 Repair Type: Non-Urgent  
 Crossing Status: Found  
 UCIP Comments: 04/18/2014 Need to contact owner. Recommend clearing sediment deposit inside pipe. (O. Magana - DWR UCIP)  
 FIELD\_STRUCT\_DESC: 24-inch corrugated metal gravity drainage pipe through the levee, 10.5 feet below the crown. Flap gate on the waterside (WS) end. [Additional Reference(s): DWR Levee Log, 2002 (HLM 1.06), listed as a 24-inch corrugated metal pipe (CMP). USACE San Joaquin O&M Manual, Unit 601 Part 1 (SJR601.1), 1967, (HLM 1.06), listed as a 24-inch CMP].  
 FS Date: 4/18/2014

View of waterward side.

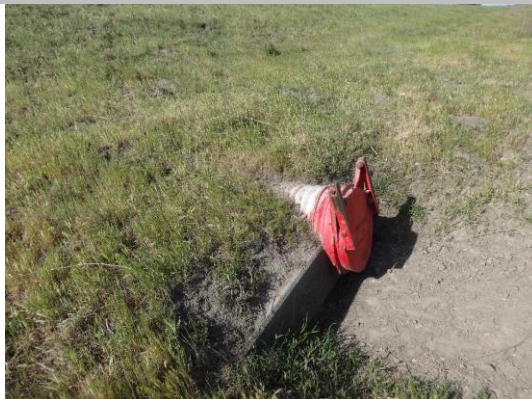
Photo 2 of 3 : UCIP\_SP\_2021\_62073\_62049.jpg

Concrete headwall and flap gate visible on waterward side.

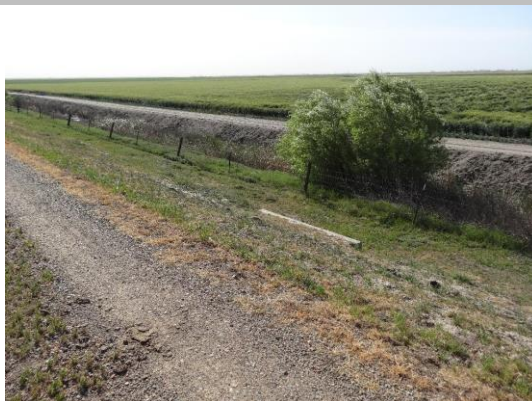
Photo 3 of 3 : UCIP\_SP\_2021\_62073\_62047.jpg

View of landward side.

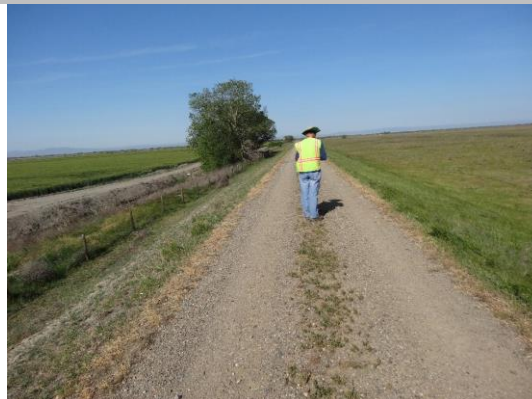
Photo 1 of 3 : UCIP\_SP\_2021\_62074\_66654.jpg

Comment Code						
Inspector Comment						
FS_ID:62074						
DS_ID:19857						
EP_NO: N/A						
Repair Type: Non-Urgent						
Crossing Status: Found						
UCIP Comments: 04/18/2014 Landward side not accessible due to dense vegetation and fence. Concrete headwall and flap gate under water therefore not able to evaluate condition. Will need to coordinate with owner to evaluate condition of crossing on waterward side and obtain access to evaluate landward side. (O. Magana - DWR UCIP)						
FIELD_STRUCT_DESC: 24-inch corrugated metal gravity drainage pipe through the levee, 17.4 feet below the crown. Flap gate on the waterside (WS) end. [Additional Reference(s): DWR Levee Log, 2002 (HLM 1.28), listed as a 24-inch corrugated metal pipe (CMP). USACE San Joaquin O&M Manual, Unit 601 Part 1 (SJR601.1), 1967, (HLM 1.27), listed as a 24-inch CMP].						
FS Date: 4/18/2014

Overview of levee crown at crossing.

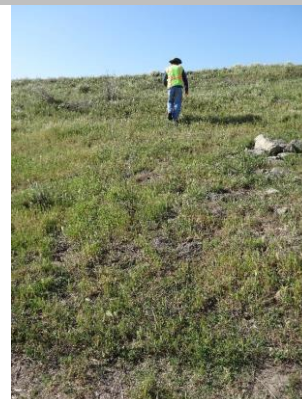
Photo 2 of 3 : UCIP\_SP\_2021\_62074\_66652.jpg

View of waterward slope.

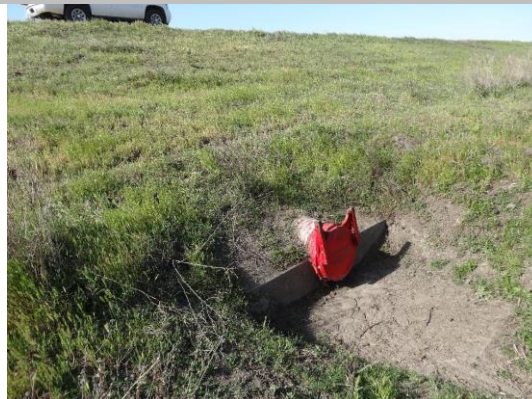
Photo 2 of 3 : UCIP\_SP\_2021\_62075\_62061.jpg

Concrete headwall and flap gate visible on waterward side.

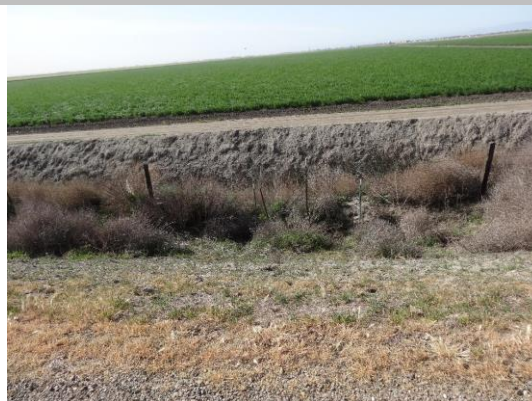
Photo 3 of 3 : UCIP\_SP\_2021\_62075\_62059.jpg

View of landward side--limited access due to fence.

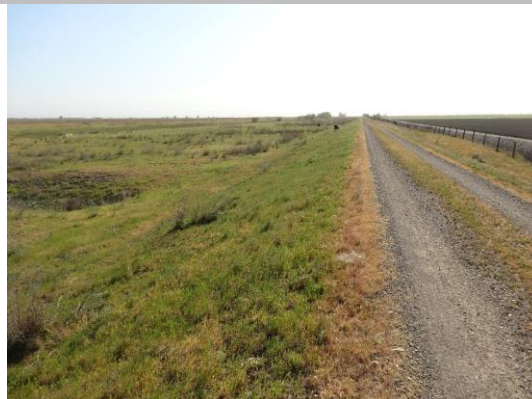
Photo 1 of 3 : UCIP\_SP\_2021\_62076\_62064.jpg

Comment Code						
Inspector Comment						
FS_ID:62076 DS_ID:19859 EP_NO: N/A Repair Type: Non-Urgent Crossing Status: Found UCIP Comments: 04/18/2014 Need to contact owner. Recommend clearing vegetation from landward side--headwall blocked. (O. Magana - DWR UCIP) FIELD_STRUCT_DESC: 24-inch corrugated metal gravity drainage pipe through the levee, 14.4 feet below the crown. Flap gate on the waterside (WS) end. [Additional Reference(s): DWR Levee Log, 2002 (HLM 2.16), listed as a 24-inch corrugated metal pipe (CMP). USACE San Joaquin O&M Manual, Unit 601 Part 1 (SJR601.1), 1967, (HLM 2.16), listed as a 24-inch CMP]. FS Date: 4/18/2014

View of waterward side.

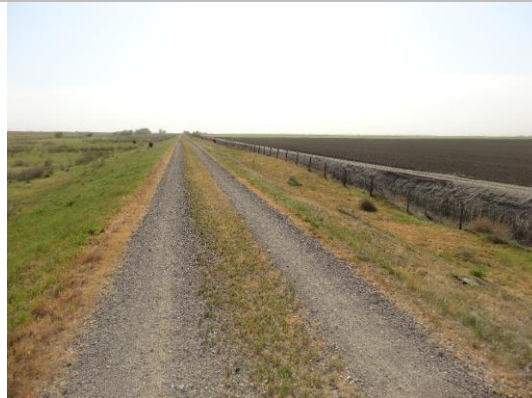
Photo 2 of 3 : UCIP\_SP\_2021\_62076\_62063.jpg

Overview of levee crown at crossing.

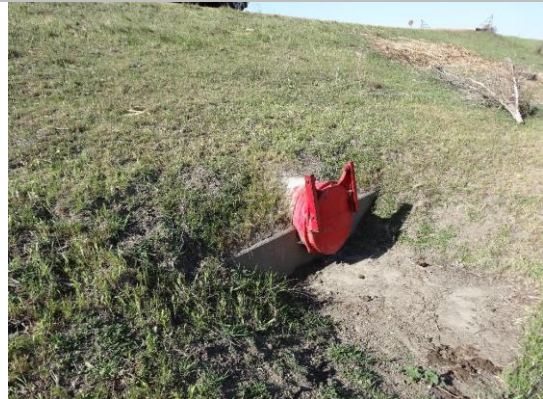
Photo 2 of 3 : UCIP\_SP\_2021\_62077\_62070.jpg

Concrete headwall and flat gate located on waterward side.

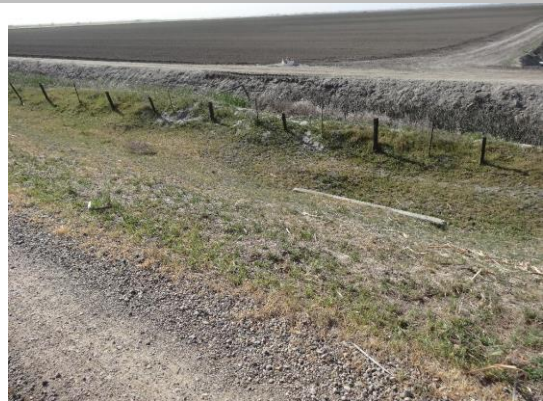
Photo 3 of 3 : UCIP\_SP\_2021\_62077\_62068.jpg

View of landward side.

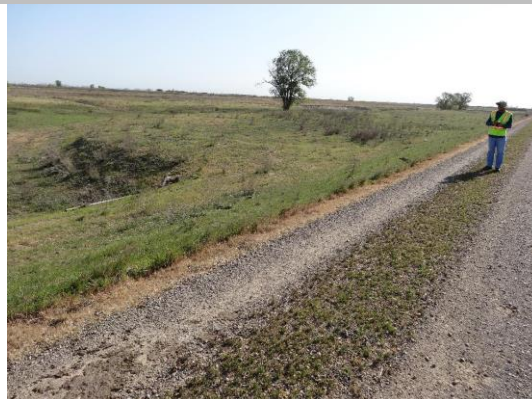
Photo 1 of 3 : UCIP\_SP\_2021\_62078\_62073.jpg

FS\_ID:62078  
DS\_ID:19861  
EP\_NO: N/A  
Repair Type: Non-Urgent  
Crossing Status: Found  
UCIP Comments: 11/09/2015 DWR Inspection section confirmed issue has been addressed. Need to coordinate with LMA to determine additional details for extent of repair. (O. Magana - DWR UCIP)04/18/2014 Soil missing behind concrete headwall on waterward side. Unable to determine if missing soil is due to sink holes, rodent activity, or due to erosion. Headwall appears to be leaning slightly forward. Reason why this crossing was labelled urgent was due to the uncertainty of damage to concrete headwall and reason for soil missing behind concrete. Need to coordinate with LMA to determine more information about repair at this location. (O. Magana -DWR UCIP) FIELD\_STRUCT\_DESC: 24-inch corrugated metal gravity drainage pipe through the levee, 2 feet below the crown. Flap gate on the waterside (WS) end. [Additional Reference(s): DWR Levee Log, 2002 (HLM 3.00), listed as a 24-inch corrugated metal pipe (CMP). USACE San Joaquin O&M Manual, Unit 601 Part 1 (SJR601.1), 1967, (HLM 3.00), listed as a 24-inch CMP].

View of waterward side.
