# Flood Control Project Maintenance Levee Inspections LMA District Cover Sheet

## Lower San Joaquin Levee District

**Flood Control Project Maintenance  
Levee Inspections  
Unit Cover Sheet**

Waterway			Bank	Unit Miles
Unit No. 01 San Joaquin River			Right	22.52
	Spring (March - May)	Summer (June - August)	(September - November) Fall	Winter (December - February)
Unit Maintenance Rating (Fall Only)				
Date of Inspection	5/4/2021 - 5/4/2021			
DWR Inspector	Corey Fujitani			
Accompanied By

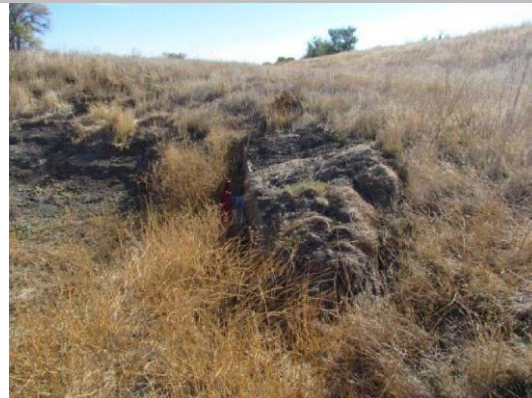
Photo 2 of 3 : UCIP\_SP\_2021\_62078\_74729.jpg

Repair to headwall located on waterward side has been addressed.

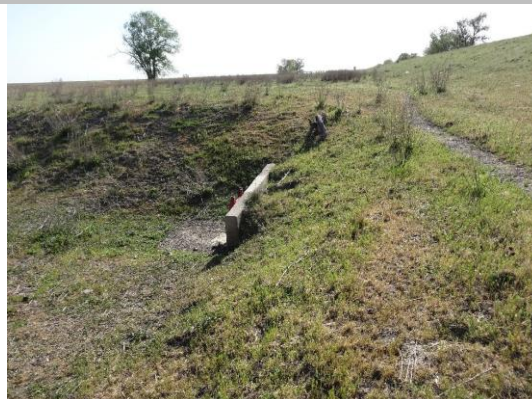
Photo 3 of 3 : UCIP\_SP\_2021\_62078\_62072.jpg

Side view of concrete headwall which appears to be slightly slanted forward--missing soil behind headwall.

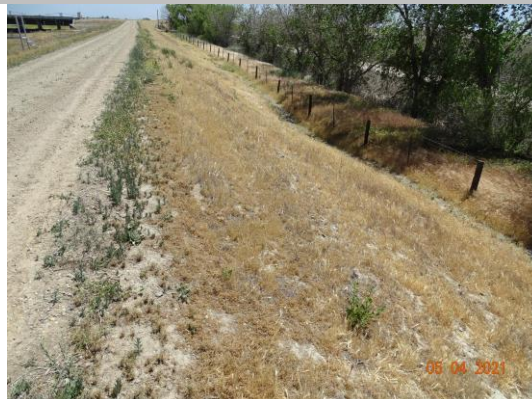
Photo 1 of 1 : SP\_2021\_NA0010\_130\_9\_20210518\_00022.jpg

LM Start	3.22	Rating **	A	Issue No.	9
LM End	3.22	Issue Type +	Ma	Location *	LS
Category	Earthen Levee			GPS Latitude/Longitude	
				Start	End
Item	Vegetation			37.200920 °	37.200920 °
				-120.696803 °	-120.696803 °
DWR ID	DWR_NA0010_12_s_2021_9				
Comment Code					
V1 : Control annual grass and weeds on the levee slopes and easements.					
Inspector Comment					
The annual vegetation is well maintained.

View of vegetation management on the landside slope. (Spring 2021)

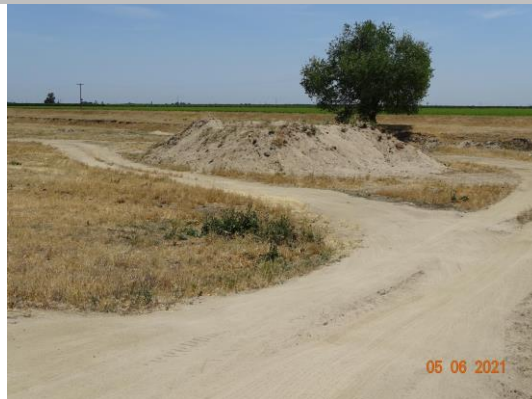
Photo 1 of 1 : SP\_2021\_NA0010\_131\_4\_20210518\_00012.jpg

LM Start	0.92	Rating **	U	Issue No.	4
LM End	0.92	Issue Type +	En	Location *	WS
Category	Rivers, Channels & Designated Floodways			GPS Latitude/Longitude	
				Start	End
Item	Encroachments			37.044899 °	37.044899 °
				-120.433995 °	-120.433995 °
DWR ID	DWR_NA0010_13_s_2021_4				
Comment Code					
Inspector Comment					
Soil material is being stored in the channel.

Material piled in the slough channel. (Spring 2021)

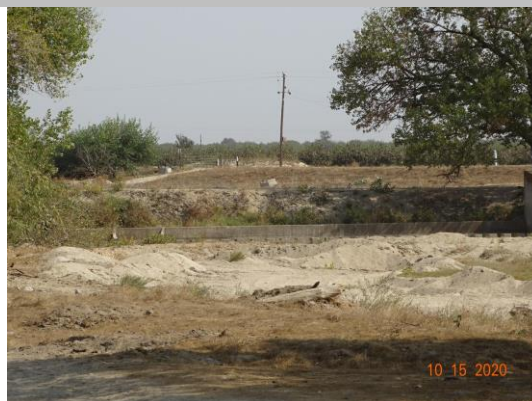
Photo 1 of 1 : SP\_2021\_NA0010\_131\_6\_20210308\_00002.jpg

LM Start	1.14	Rating **	U	Issue No.	6
LM End	1.14	Issue Type +	En	Location *	WS
Category	Earthen Levee			GPS Latitude/Longitude	
				Start	End
Item	Encroachments			37.045541 °	37.045541 °
				-120.430014 °	-120.430014 °
DWR ID	DWR_NA0010_13_f_2015_6				
Comment Code					
WL : Wall					
Inspector Comment					
Sand dam may have been blown out due to high flows in 2017 but has been restored. The sand dam referenced in this issue is an unauthorized construction in the channel by the landowner. It blocks the entire channel.

Downstream view of sand dam constructed upstream of the Ash Slough Drop Structure 4. (Fall 2020)

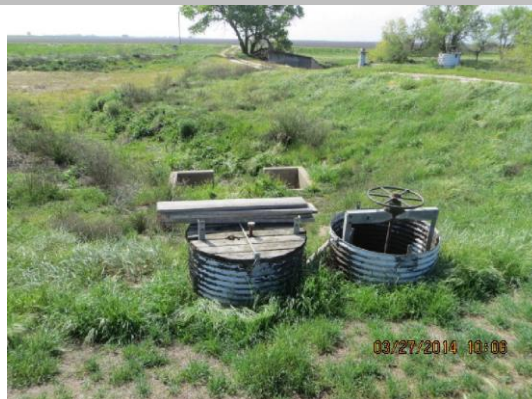
Photo 1 of 3 : UCIP\_SP\_2021\_62080\_59385.jpg

Comment Code						
Inspector Comment						
FS_ID:62080 DS_ID:19727 EP_NO: N/A Repair Type: Non-Urgent Crossing Status: Found UCIP Comments: 03/27/2014 Appears abandoned and if so should be done so properly. Pipe filled with soil on WS at outlet. Actuator missing from slide gate on WS shoulder. (W. Wylie - DWR UCIP) FIELD_STRUCT_DESC: [Rounder Irrigation Structure] 1 of 2: 36-inch corrugated metal gravity drainage pipe through the levee, 12.3 feet below the crown. Slide gate in a 48-inch corrugated metal pipe (CMP) riser on the waterside (WS) slope. 6-foot by 12-foot concrete distribution box on the landside (LS). 7-foot by 14-foot concrete outlet structure on the WS toe. [Additional Reference(s): DWR Levee Log, 2002 (HLM 1.14), listed as a 36-inch corrugated metal pipe (CMP). USACE San Joaquin O&M Manual, Unit 601 Part 1 (SJR601.1), 1967, (HLM 1.14), listed as a 36-inch CMP]. FS Date: 3/27/2014

Slide gate in CMP riser on WS shoulder.

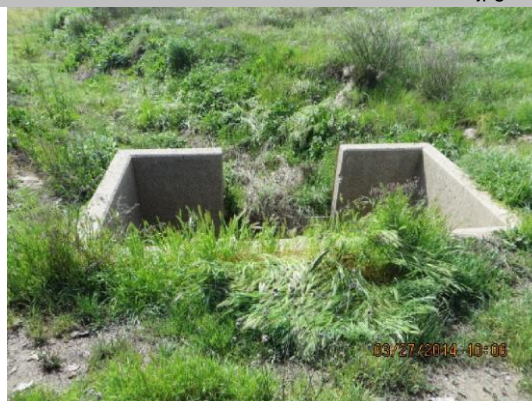
Photo 2 of 3 : UCIP\_SP\_2021\_62080\_59384.jpg

Concrete box on WS toe.

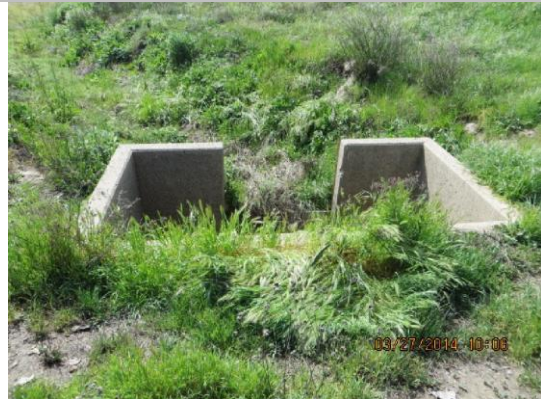
Photo 2 of 3 : UCIP\_SP\_2021\_62081\_59392.jpg

Concrete distribution box on WS toe.

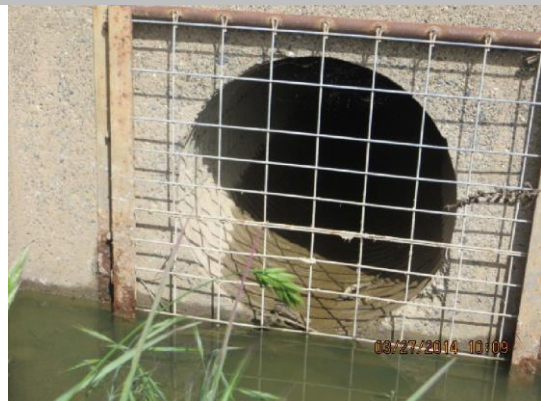
Photo 3 of 3 : UCIP\_SP\_2021\_62081\_59391.jpg

Pipe at outlet on WS toe.

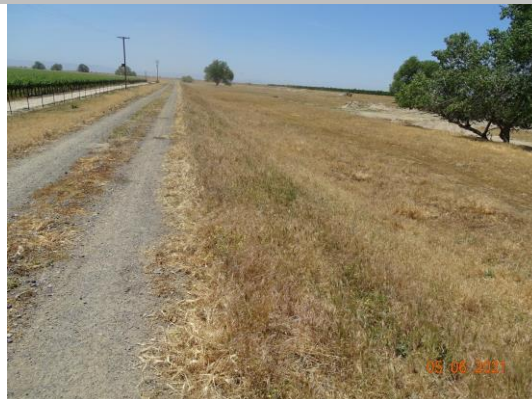
Photo 1 of 1 : SP\_2021\_NA0010\_132\_7\_20210518\_00010.jpg

LM Start	0.01	Rating **	M	Issue No.	7
LM End	1.11	Issue Type +	Ma	Location *	WS
Category	Earthen Levee			GPS Latitude/Longitude	
				Start	End
Item	Vegetation			37.032557 °	37.044786 °
				-120.441201 °	-120.430250 °
DWR ID	DWR_NA0010_14_s_2021_7				
Comment Code					
V1 : Control annual grass and weeds on the levee slopes and easements.					
Inspector Comment

View of the waterside slope looking downstream. (Spring 2021)

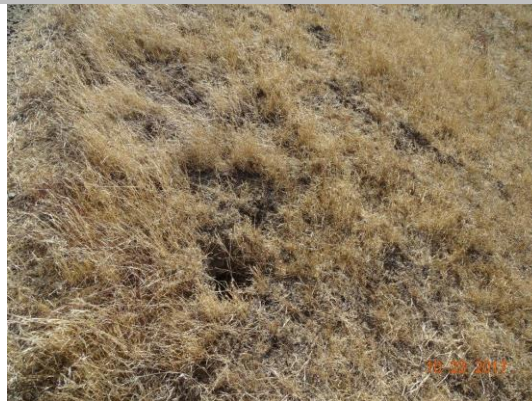
Photo 1 of 1 : SP\_2021\_NA0010\_132\_5\_20210308\_00002.jpg

LM Start	0.25	Rating **	A/W	Issue No.	5
LM End	0.25	Issue Type +	Ma	Location *	LS
Category	Earthen Levee			GPS Latitude/Longitude	
				Start	End
Item	Animal Control			37.035841 °	37.035841 °
				-120.439795 °	-120.439795 °
DWR ID	DWR_NA0010_14_f _ 2017_5				
Comment Code					
A3 : No rodents visible, but rodent burrows visible; need to backfill and compact or grout burrows.					
Inspector Comment

Looking at the landside slope.

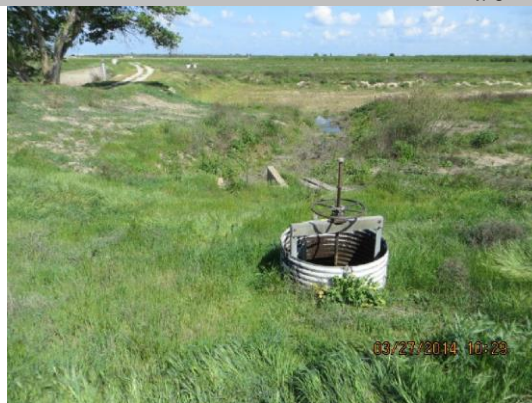
Photo 1 of 3 : UCIP\_SP\_2021\_62082\_59398.jpg

Comment Code					
Inspector Comment					
FS_ID:62082 DS_ID:19909 EP_NO: N/A Repair Type: Non-Urgent Crossing Status: Found UCIP Comments: 03/27/2014 Lid should be installed on CMP riser on WS slope, could be a safety hazard. Also dense vegetation limits the inspector's visibility to identify signs of pipe failure (leaks) along the slope. Recommend removing vegetation along pipe alignment to conduct proper inspection of structure. (O. Magana - DWR UCIP) FIELD_STRUCT_DESC: [Rounder Irrigation Structure] 36-inch corrugated metal gravity irrigation pipe through the levee, 10 feet below the crown. Slide gate in a 48-inch corrugated metal pipe (CMP) riser on the waterside (WS) slope. 6-foot by 7-foot concrete distribution box at the WS toe. Slots for wooden flashboards on the WS of the box. 7-foot by 9-foot concrete distribution box on the landside (LS), 20 feet from the toe. [Additional Reference(s): DWR Levee Log, 2002 (HLM 1.15), listed as a 36-inch corrugated metal pipe (CMP). USACE San Joaquin O&M Manual, Unit 601 Part 1 (SJR601.1), 1967, (HLM 1.15), listed as a 36-inch CMP]. FS Date: 3/27/2014

Slide gate in CMP riser and outlet/inlet structure visible in background at WS toe.

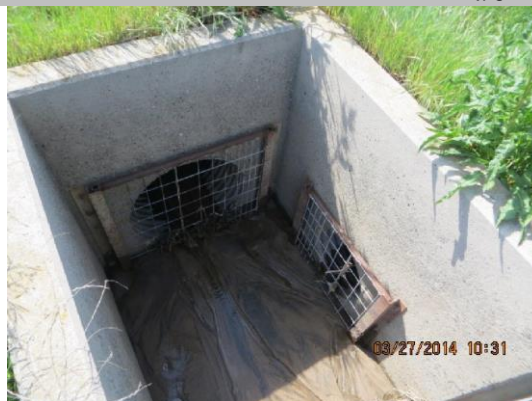
Photo 2 of 3 : UCIP\_SP\_2021\_62082\_59396.jpg

concrete inlet/outlet at WS toe.

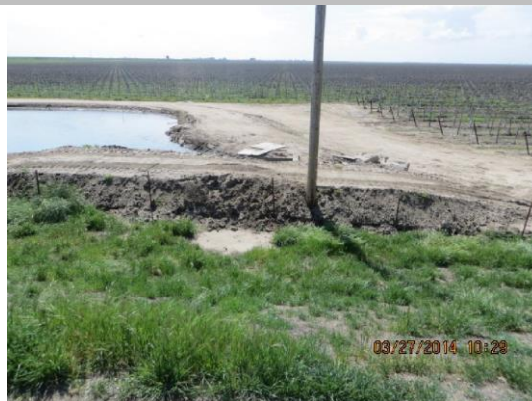
Photo 3 of 3 : UCIP\_SP\_2021\_62082\_59397.jpg

Concrete distribution box visible next to power pole off LS toe.

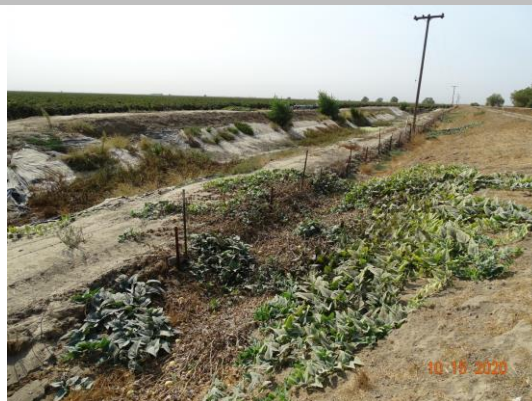
Photo 1 of 1 : SP\_2021\_NA0010\_132\_3\_20210308\_00001.jpg

LM Start	1.15	Rating **	A/W	Issue No.	3
LM End	1.26	Issue Type +	En	Location *	LS
Category	Earthen Levee			GPS Latitude/Longitude	
				Start	End
Item	Encroachments			37.044939 °	37.045416 °
				-120.429636 °	-120.427719 °
DWR ID	DWR_NA0010_14_f_2020_3				
Comment Code					
DT : Ditch					
Inspector Comment					
Retention pond dug approx. 20 feet from landside toe.

Retention basin dug approximately 20 ft from the landside toe. (Fall 2020)

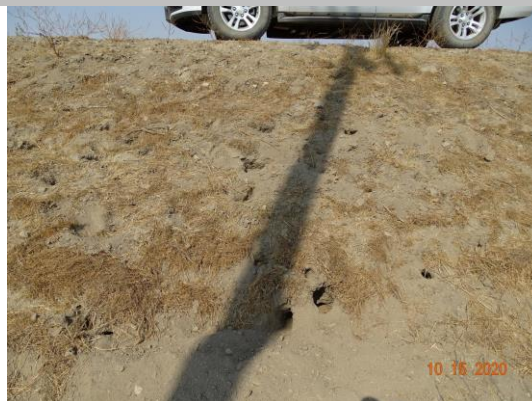
Photo 1 of 1 : SP\_2021\_NA0010\_132\_79\_20210308\_00003.jpg

LM Start	1.24	Rating **	M	Issue No.	79
LM End	1.24	Issue Type +	Ma	Location *	LS
Category	Earthen Levee			GPS Latitude/Longitude	
				Start	End
Item	Animal Control			37.045343 °	37.045343 °
				-120.428007 °	-120.428007 °
DWR ID	DWR_NA0010_14_s_2021_79				
Comment Code					
A3 : No rodents visible, but rodent burrows visible; need to backfill and compact or grout burrows.					
Inspector Comment					
Several rodent holes are noted on the landside at this location.

View of rodent burrows on the landside slope. (Fall 2020)

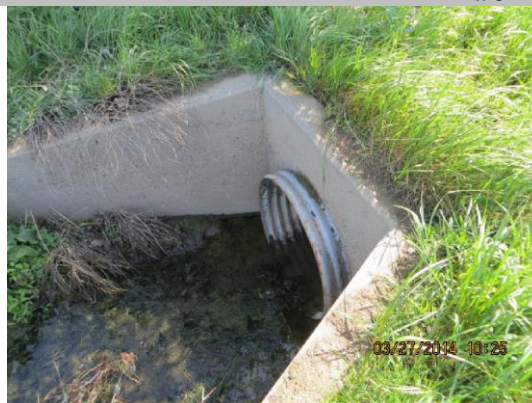
Photo 1 of 3 : UCIP\_SP\_2021\_62083\_59402.jpg

Comment Code						
Inspector Comment						
FS_ID:62083 DS_ID:19910 EP_NO: N/A Repair Type: No Action Needed Crossing Status: Found UCIP Comments: FIELD_STRUCT_DESC: 36-inch corrugated metal gravity drainage pipe through the levee, 9 feet below the crown. Slide gate in a 42-inch corrugated metal pipe (CMP) riser on the waterside (WS) slope. Concrete U-shaped headwall on the WS end. Pipe terminates into a concrete ditch on the landside (LS). [Additional Reference(s): DWR Levee Log, 2002 (HLM 1.26), listed as a 36-inch corrugated metal pipe (CMP). USACE San Joaquin O&M Manual, Unit 601 Part 1 (SJR601.1), 1967, (HLM 1.26), listed as a 36-inch CMP]. FS Date: 3/27/2014

Concrete U-shaped headwall on WS toe.

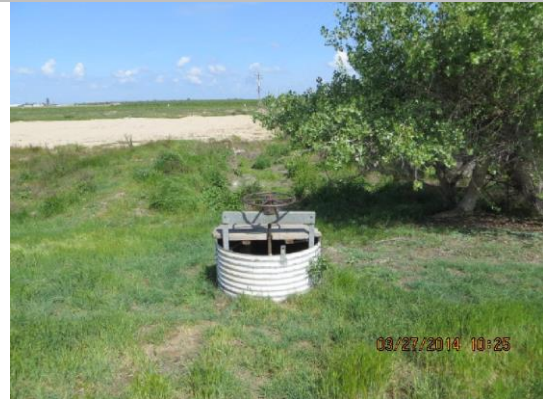
Photo 2 of 3 : UCIP\_SP\_2021\_62083\_59401.jpg

slidegate in CMP riser on WS slope.

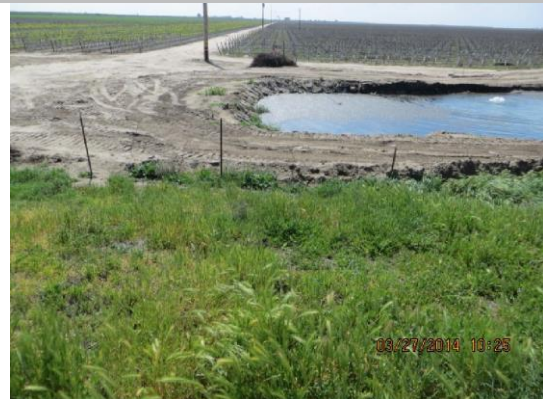
Photo 3 of 3 : UCIP\_SP\_2021\_62083\_59400.jpg

Inlet assumed to be within irrigation structure off LS toe.

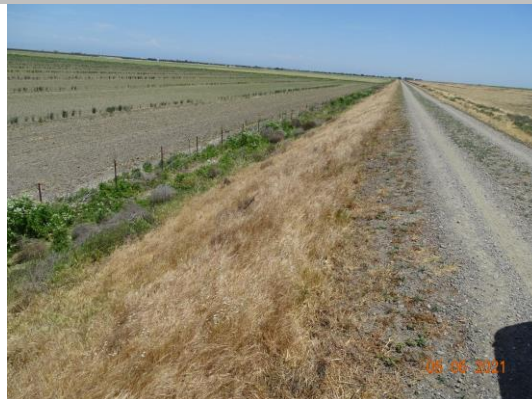
Photo 1 of 1 : SP\_2021\_NA0010\_133\_4\_20210518\_00012.jpg

LM Start	0.07	Rating **	M	Issue No.	4
LM End	0.60	Issue Type +	Ma	Location *	LS
Category	Earthen Levee			GPS Latitude/Longitude	
				Start	End
Item	Vegetation			36.996562 °	36.996552 °
				-120.409246 °	-120.399599 °
DWR ID	DWR_NA0010_15_s_2021_4				
Comment Code					
V1 : Control annual grass and weeds on the levee slopes and easements.					
Inspector Comment

Looking upstream along the landside slope. (Spring 2021)

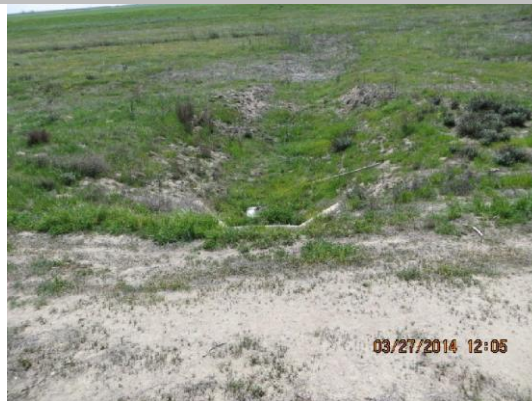
Photo 1 of 3 : UCIP\_SP\_2021\_62084\_59448.jpg

Comment Code						
Inspector Comment						
FS_ID:62084						
DS_ID:19911						
EP_NO: N/A						
Repair Type: No Action Needed						
Crossing Status: Found						
UCIP Comments:						
FIELD_STRUCT_DESC: 30-inch by 30-inch square reinforced concrete box gravity drainage culvert through the levee, 10.1 feet below the crown. Flap gate on the waterside (WS) end. Concrete headwall on the landside (LS) end. Concrete U-shaped headwall on the WS end.						
[Additional Reference(s): DWR Levee Log, 2002 (HLM 0.49), listed as a 30-inch square reinforced concrete box culvert (RCBC). USACE San Joaquin O&M Manual, Unit 601 Part 1 (SJR601.1), 1967, (HLM 0.48), listed as a 2.5-feet by 2.5-feet RCBC].						
FS Date: 3/27/2014

Concrete headwall on WS toe.

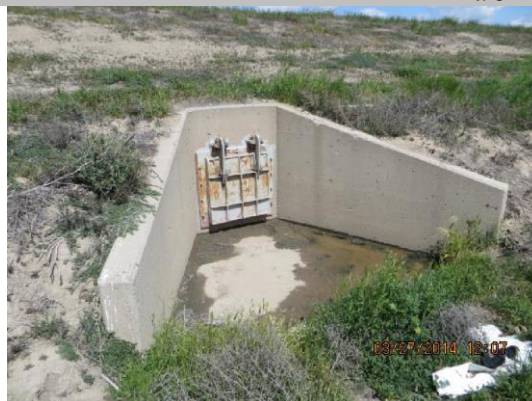
Photo 2 of 3 : UCIP\_SP\_2021\_62084\_59449.jpg

Flapgate on Concrete headwall at WS toe.

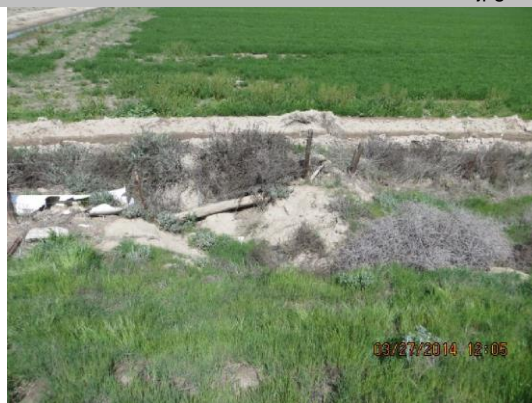
Photo 3 of 3 : UCIP\_SP\_2021\_62084\_59447.jpg

Concrete headwall on LS toe.

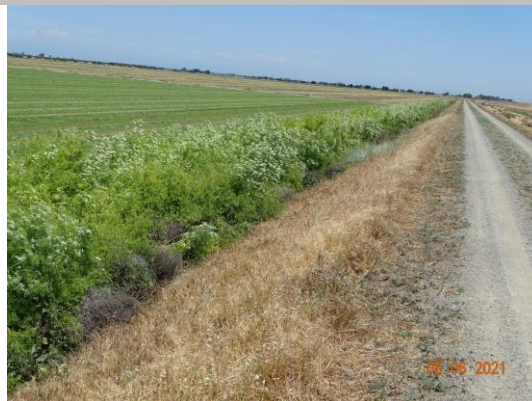
Photo 1 of 1 : SP\_2021\_NA0010\_133\_5\_20210518\_00013.jpg

LM Start	0.60	Rating **	U	Issue No.	5
LM End	2.01	Issue Type +	Ma	Location *	LS
Category	Earthen Levee			GPS Latitude/Longitude	
				Start	End
Item	Vegetation			36.996552 °	36.996594 °
				-120.399599 °	-120.374154 °
DWR ID	DWR_NA0010_15_s_2021_5				
Comment Code					
V1 : Control annual grass and weeds on the levee slopes and easements.					
Inspector Comment

View of vegetation growing on the landside slope and toe. (Spring 2021)

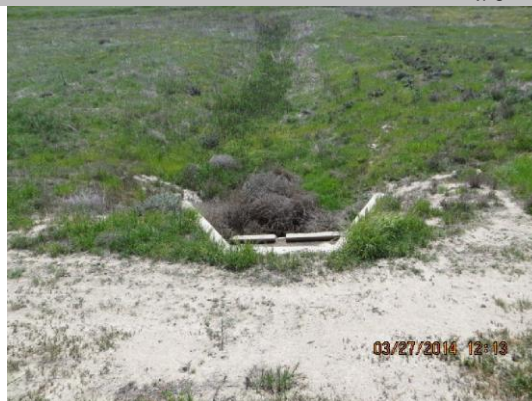
Photo 1 of 3 : UCIP\_SP\_2021\_62085\_59452.jpg

FS\_ID:62085  
DS\_ID:19912  
EP\_NO: N/A  
Repair Type: Non-Urgent  
Crossing Status: Found  
UCIP Comments: 03/27/2014 Dense vegetation limits the inspector's visibility to identify signs of pipe failure (leaks) along the landward slope. Recommend removing vegetation along pipe alignment to conduct proper inspection of structure. (W. Wylie - DWR UCIP)  
FIELD\_STRUCT\_DESC: 30-inch by 30-inch square reinforced concrete box gravity drainage culvert through the levee, 8.5 feet below the crown. Flap gate on the waterside (WS) end. Concrete headwall on the landside (LS) end. Concrete U-shaped headwall on the WS end.  
[Additional Reference(s): DWR Levee Log, 2002 (HLM 1.01), listed as a 30-inch square reinforced concrete box culvert (RCBC). USACE San Joaquin O&M Manual, Unit 601 Part 1 (SJR601.1), 1967, (HLM 1.01), listed as a 2.5-feet by 2.5-feet RCBC].  
FS Date: 3/27/2014

Concrete headwall on WS toe.

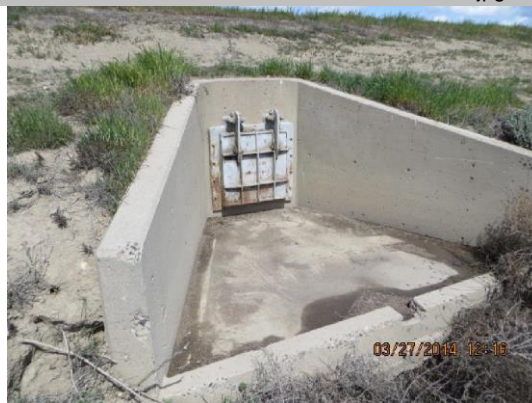
Photo 2 of 3 : UCIP\_SP\_2021\_62085\_59453.jpg

Flapgate on concrete headwall at WS toe.

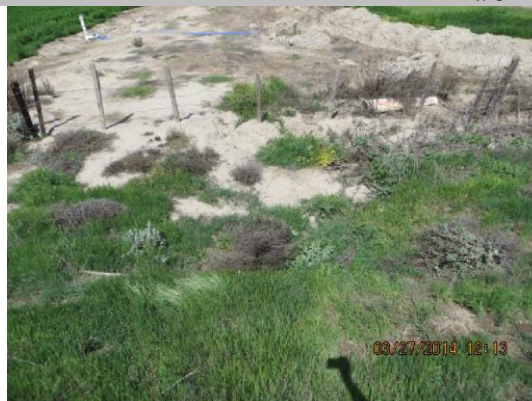
Photo 3 of 3 : UCIP\_SP\_2021\_62085\_59451.jpg

Concrete headwall on LS toe.

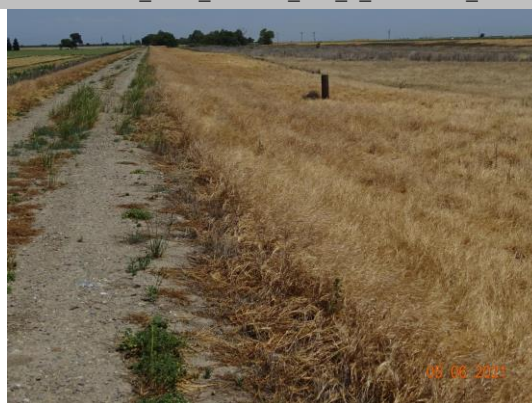
Photo 1 of 1 : SP\_2021\_NA0010\_133\_7\_20210518\_00014.jpg

LM Start	1.52	Rating **	U	Issue No.	7
LM End	2.01	Issue Type +	Ma	Location *	WS
Category	Earthen Levee			GPS Latitude/Longitude	
				Start	End
Item	Vegetation			36.996570 °	36.996594 °
				-120.382936 °	-120.374154 °
DWR ID	DWR_NA0010_15_s_2021_7				
Comment Code					
V1 : Control annual grass and weeds on the levee slopes and easements.					
Inspector Comment

Looking upstream along the waterside slope. (Spring 2021)

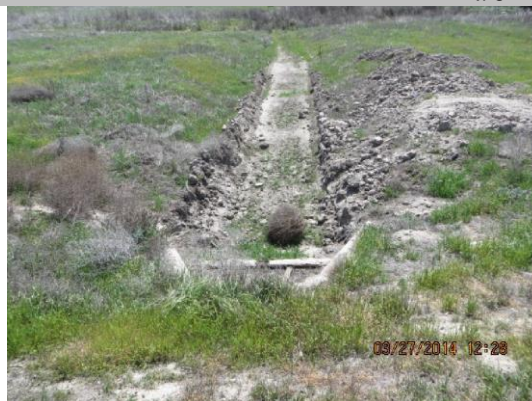
Photo 1 of 3 : UCIP\_SP\_2021\_62086\_59456.jpg

Comment Code						
Inspector Comment						
FS_ID:62086						
DS_ID:19913						
EP_NO: N/A						
Repair Type: Non-Urgent						
Crossing Status: Found						
UCIP Comments: 03/27/2014 Excessive vegetation at inlet on LS toe.

Concrete headwall on WS toe.

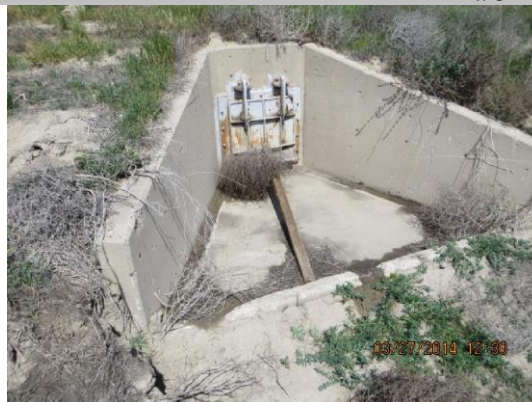
Photo 2 of 3 : UCIP\_SP\_2021\_62086\_59457.jpg

Flapgate on concrete headwall at WS toe.

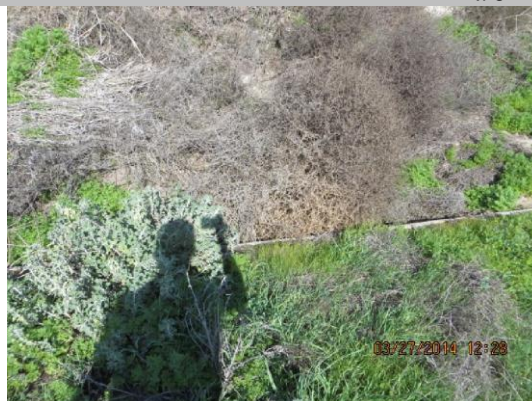
Photo 3 of 3 : UCIP\_SP\_2021\_62086\_59455.jpg

Concrete headwall on LS toe. Note excessive vegetation buildup.

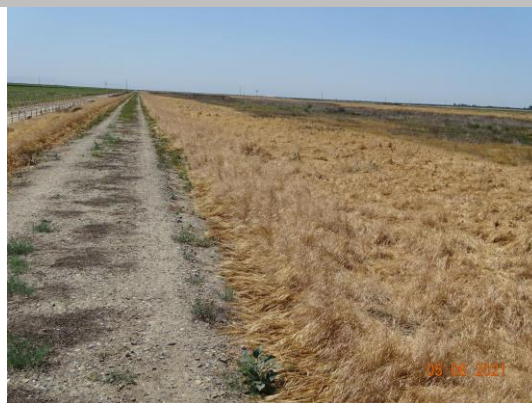
Photo 1 of 1 : SP\_2021\_NA0010\_134\_6\_20210518\_00009.jpg

LM Start	0.22	Rating **	U	Issue No.	6
LM End	1.95	Issue Type +	Ma	Location *	WS
Category	Earthen Levee			GPS Latitude/Longitude	
				Start	End
Item	Vegetation			36.995417 °	36.995497 °
				-120.405021 °	-120.373651 °
DWR ID	DWR_NA0010_16_s_2021_6				
Comment Code					
V1 : Control annual grass and weeds on the levee slopes and easements.					
Inspector Comment

View of the waterside slope looking downstream. (Spring 2021)

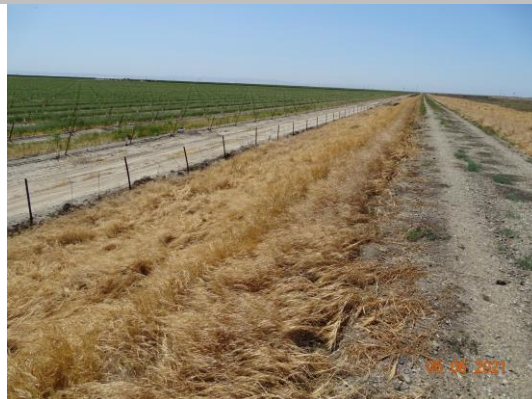
Photo 1 of 1 : SP\_2021\_NA0010\_134\_5\_20210518\_00011.jpg

LM Start	0.69	Rating **	U	Issue No.	5
LM End	1.95	Issue Type +	Ma	Location *	LS
Category	Earthen Levee			GPS Latitude/Longitude	
				Start	End
Item	Vegetation			36.995437 °	36.995497 °
				-120.396508 °	-120.373650 °
DWR ID	DWR_NA0010_16_s_2021_5				
Comment Code					
V1 : Control annual grass and weeds on the levee slopes and easements.					
Inspector Comment

View of vegetation on the landside slope. (Spring 2021)

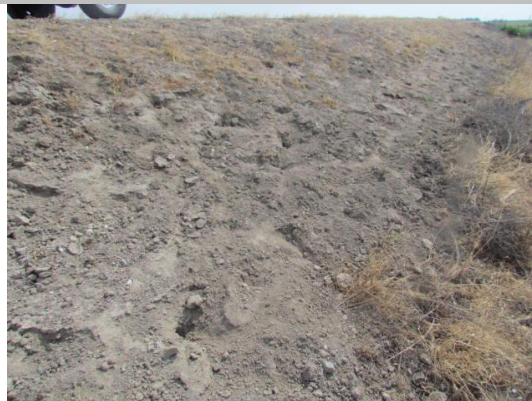
Photo 1 of 1 : SP\_2021\_NA0010\_134\_92\_20210308\_00005.jpg

LM Start	0.93	Rating **	M	Issue No.	92
LM End	0.93	Issue Type +	Ma	Location *	LS
Category	Earthen Levee			GPS Latitude/Longitude	
				Start	End
Item	Animal Control			36.995439 °	36.995439 °
				-120.392146 °	-120.392146 °
DWR ID	DWR_NA0010_16_s_2015_92				
Comment Code					
A3 : No rodents visible, but rodent burrows visible; need to backfill and compact or grout burrows.					
Inspector Comment					
Several rodent holes are identified within this section.

Looking at several rodent holes on landward slope.

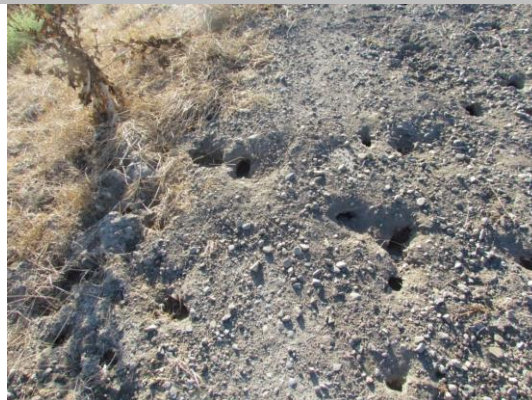
Photo 1 of 1 : SP\_2021\_NA0010\_134\_3\_20210308\_00002.jpg

LM Start	1.09	Rating **	M	Issue No.	3
LM End	1.09	Issue Type +	Ma	Location *	CR
Category	Earthen Levee			GPS Latitude/Longitude	
				Start	End
Item	Animal Control			36.995433 °	36.995433 °
				-120.389190 °	-120.389190 °
DWR ID	DWR_NA0010_16_f _ 2016_3				
Comment Code					
A3 : No rodents visible, but rodent burrows visible; need to backfill and compact or grout burrows.					
Inspector Comment					
Several rodent holes are identified on the levee crown.

Looking at several rodent holes and mole holes on levee crown.

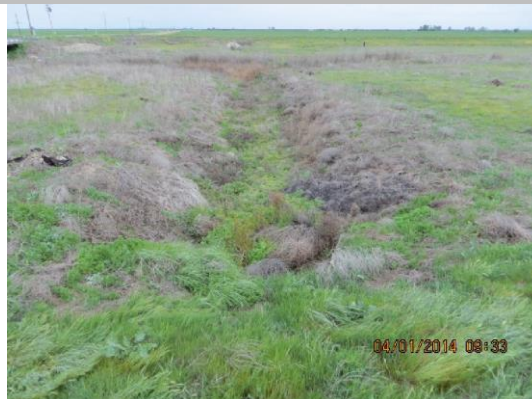
Photo 1 of 3 : UCIP\_SP\_2021\_62089\_59681.jpg

FS\_ID:62089  
DS\_ID:19915  
EP\_NO: N/A  
Repair Type: Non-Urgent  
Crossing Status: Found  
UCIP Comments: 04/01/2014 Dense vegetation buildup at landside toe--recommend clearing. (W. Wylie - DWR UCIP)  
FIELD\_STRUCT\_DESC: 30-inch by 30-inch square reinforced concrete box gravity drainage culvert through the levee, 8.5 feet below the crown. Two concrete cutoff walls. Flap gate on the waterside (WS) end. Concrete headwall on the landside (LS) end. Concrete U-shaped headwall on the WS end. [Additional Reference(s): DWR Levee Log, 2002 (HLM 1.46), listed as a 30-inch square reinforced concrete box culvert (RCBC). USACE San Joaquin O&M Manual, Unit 601 Part 1 (SJR601.1), 1967, (HLM 1.46), listed as a 2.5-feet by 2.5-feet RCBC].  
FS Date: 4/1/2014 8:12:00 AM

Concrete headwall on WS toe with channel.

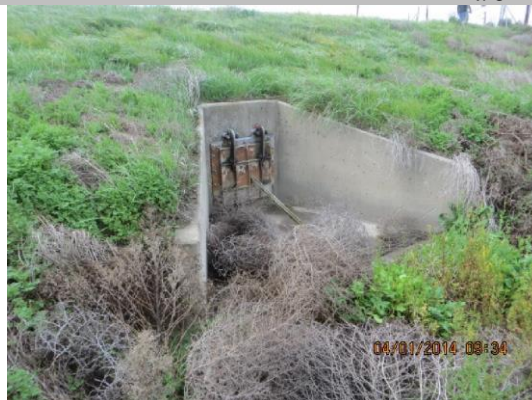
Photo 2 of 3 : UCIP\_SP\_2021\_62089\_59680.jpg

Flapgate on headwall at WS toe.

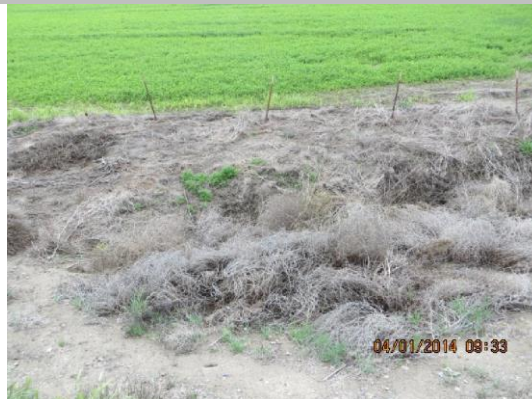
Photo 3 of 3 : UCIP\_SP\_2021\_62089\_59682.jpg

Concrete headwall on LS toe covered in vegetation/tumble weeds.

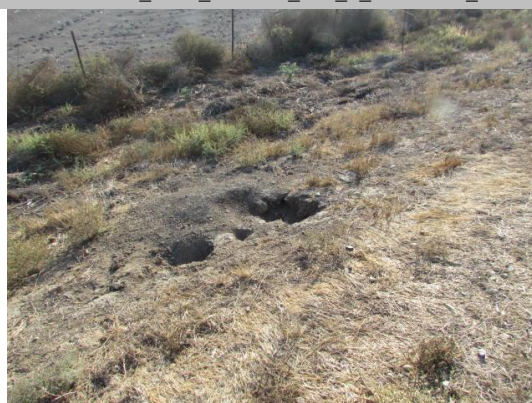
Photo 1 of 1 : SP\_2021\_NA0010\_134\_2\_20210308\_00001.jpg

LM Start	1.77	Rating **	U	Issue No.	2
LM End	1.77	Issue Type +	Ma	Location *	LS
Category	Earthen Levee			GPS Latitude/Longitude	
				Start	End
Item	Animal Control			36.995487 °	36.995487 °
				-120.377054 °	-120.377054 °
DWR ID	DWR_NA0010_16_f_2014_2				
Comment Code					
A3 : No rodents visible, but rodent burrows visible; need to backfill and compact or grout burrows.					
Inspector Comment					
Large rodent holes are on the landside slope.

Looking southwest at several rodent holes on landward slope.

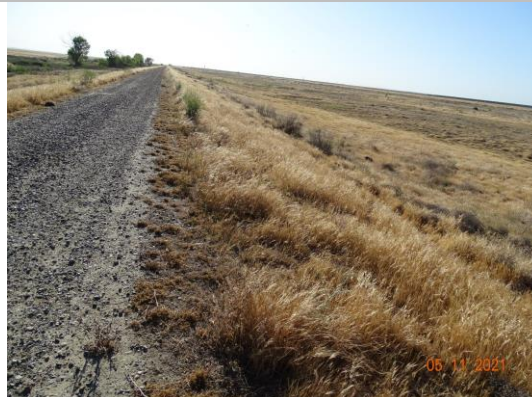
Photo 1 of 1 : SP\_2021\_NA0010\_135\_13\_20210518\_00035.jpg

LM Start	0.00	Rating **	U	Issue No.	13
LM End	7.62	Issue Type +	Ma	Location *	WS
Category	Earthen Levee			GPS Latitude/Longitude	
				Start	End
Item	Vegetation			36.976437 °	36.883195 °
				-120.374709 °	-120.319412 °
DWR ID	DWR_NA0010_17_s_2021_13				
Comment Code					
V1 : Control annual grass and weeds on the levee slopes and easements.					
Inspector Comment

View of the waterside slope looking upstream. (Spring 2021)

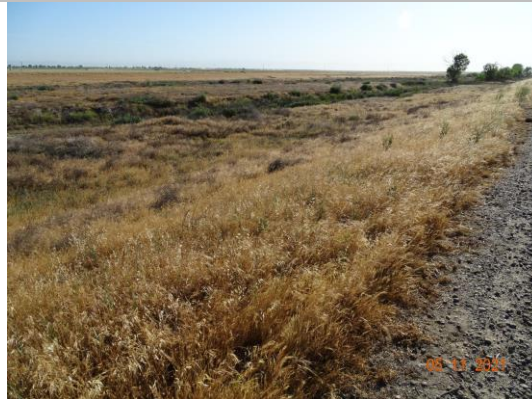
Photo 1 of 1 : SP\_2021\_NA0010\_135\_12\_20210520\_00036.jpg

LM Start	0.00	Rating **	U	Issue No.	12
LM End	7.61	Issue Type +	Ma	Location *	LS
Category	Earthen Levee			GPS Latitude/Longitude	
				Start	End
Item	Vegetation			36.976438 °	36.883245 °
				-120.374709 °	-120.319430 °
DWR ID	DWR_NA0010_17_s_2021_12				
Comment Code					
V1 : Control annual grass and weeds on the levee slopes and easements.					
Inspector Comment

View of the vegetation on the landside slope looking upstream. (Spring 2021)

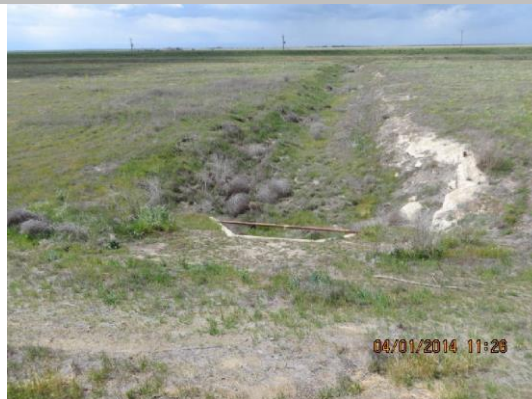
Photo 1 of 3 : UCIP\_SP\_2021\_62099\_59710.jpg

FS\_ID:62099  
DS\_ID:19916  
EP\_NO: N/A  
Repair Type: Non-Urgent  
Crossing Status: Found  
UCIP Comments: 04/01/2014 Dense vegetation limits the inspector's visibility to identify signs of pipe failure (leaks) along the landward slope. Recommend removing vegetation along pipe alignment to conduct proper inspection of structure. (W. Wylie - DWR UCIP)  
FIELD\_STRUCT\_DESC: 48-inch by 60-inch reinforced concrete box gravity drainage culvert through the levee, 14.6 feet below the crown. Flap gate on the waterside (WS) end. Concrete headwall on the landside (LS) end. Concrete U-shaped headwall on the WS end.  
[Additional Reference(s): DWR Levee Log, 2002 (HLM 2.58), listed as a 48-inch by 60-inch reinforced concrete box culvert (RCBC). USACE San Joaquin O&M Manual, Unit 601 Part 1 (SJR601.1), 1967, (HLM 2.58), listed as a 5-feet by 4-feet RCBC].  
FS Date: 4/1/2014

Concrete headwall at channel on WS toe.

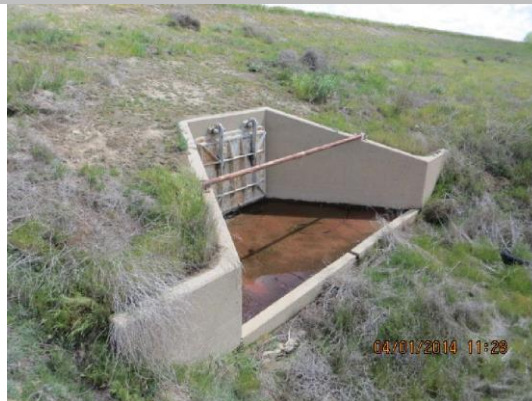
Photo 2 of 3 : UCIP\_SP\_2021\_62099\_59711.jpg

Flapgate on Concrete headwall at WS toe.

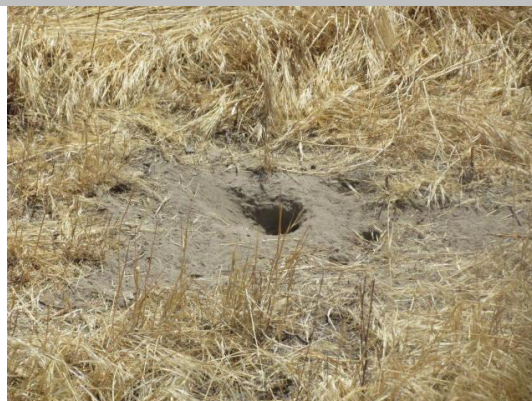
Photo 1 of 1 : SP\_2021\_NA0010\_135\_4\_20210308\_00002.jpg

LM Start	6.51	Rating **	M	Issue No.	4
LM End	6.72	Issue Type +	Ma	Location *	LS
Category	Earthen Levee			GPS Latitude/Longitude	
				Start	End
Item	Animal Control			36.898093 °	36.895300 °
				-120.326689 °	-120.325322 °
DWR ID	DWR_NA0010_17_s_2012_4				
Comment Code					
A1 : Exterminate rodents and backfill and compact or grout burrows.					
Inspector Comment					
Several rodent holes are identified within this reach.

Looking at typical view of rodent holes on landward slope.

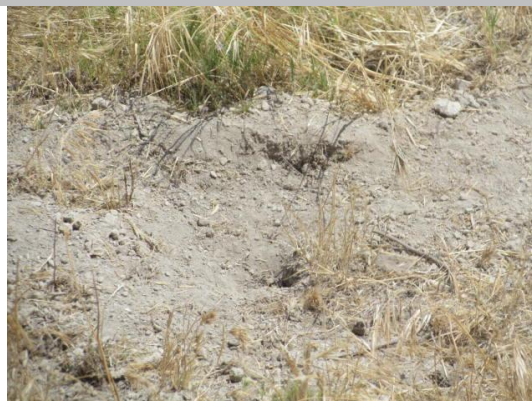
Photo 1 of 1 : SP\_2021\_NA0010\_135\_5\_20210308\_00003.jpg

LM Start	7.27	Rating **	M	Issue No.	5
LM End	7.38	Issue Type +	Ma	Location *	LS
Category	Earthen Levee			GPS Latitude/Longitude	
				Start	End
Item	Animal Control			36.887852 °	36.886388 °
				-120.321668 °	-120.320950 °
DWR ID	DWR_NA0010_17_s_2012_5				
Comment Code					
A3 : No rodents visible, but rodent burrows visible; need to backfill and compact or grout burrows.					
Inspector Comment					
Several rodent holes are identified within this reach.

Looking at typical view of rodent holes on landward slope.

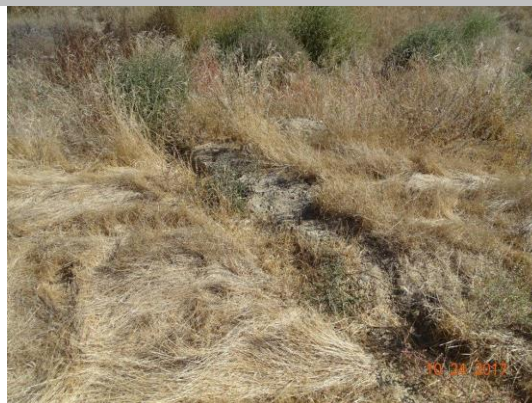
Photo 1 of 1 : SP\_2021\_NA0010\_135\_24\_20210308\_00010.jpg

LM Start	8.15	Rating **	M	Issue No.	24
LM End	8.15	Issue Type +	Ma	Location *	LS
Category	Earthen Levee			GPS Latitude/Longitude	
				Start	End
Item	Animal Control			36.875525 °	36.875525 °
				-120.317788 °	-120.317788 °
DWR ID	DWR_NA0010_17_f_2017_24				
Comment Code					
A3 : No rodents visible, but rodent burrows visible; need to backfill and compact or grout burrows.					
Inspector Comment					
Rodent holes are on the landside and crown of levee. Rodent holes have caused some erosion on the landside slope.

Looking east at the landside slope.

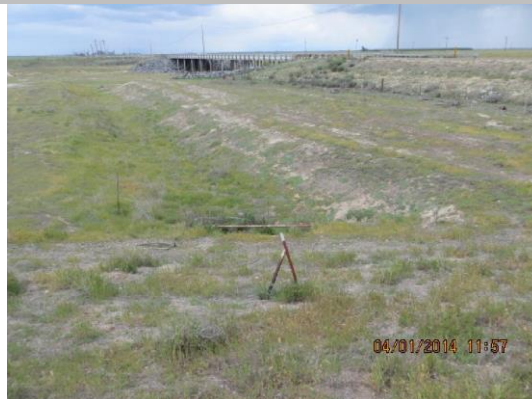
Photo 1 of 3 : UCIP\_SP\_2021\_62092\_59718.jpg

Comment Code						
Inspector Comment						
FS_ID:62092 DS_ID:19922 EP_NO: N/A Repair Type: No Action Needed Crossing Status: Found UCIP Comments: FIELD_STRUCT_DESC: 48-inch by 60-inch reinforced concrete box gravity drainage culvert through the levee, 16.5 feet below the crown. Flap gate on the waterside (WS) end. Concrete headwall on the landside (LS) end. Concrete U-shaped headwall on the WS end. [Additional Reference(s): DWR Levee Log, 2002 (HLM 8.38), listed as a 48-inch by 60-inch reinforced concrete box culvert (RCBC). USACE San Joaquin O&M Manual, Unit 601 Part 1 (SJR601.1), 1967, (HLM 8.38), listed as a 5-feet by 4-feet RCBC]. FS Date: 4/1/2014

Concrete headwall and channel on WS toe.

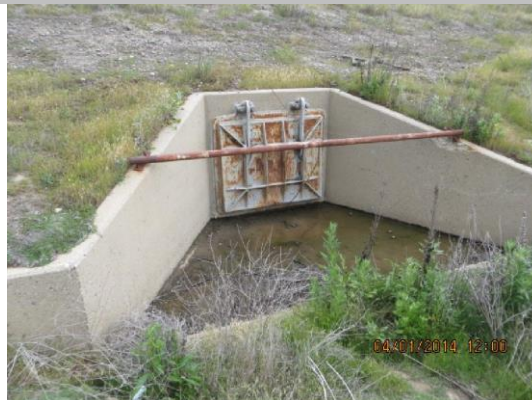
Photo 2 of 3 : UCIP\_SP\_2021\_62092\_59720.jpg

Flapgate on concrete headwall at WS toe.

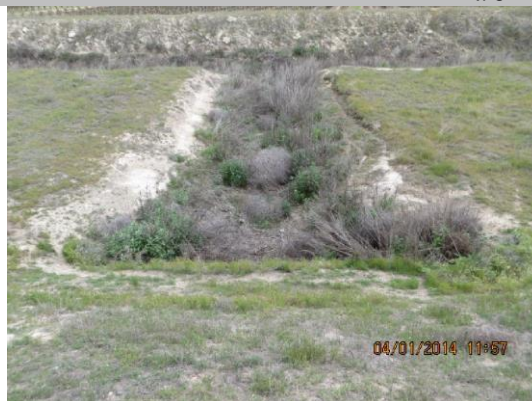
Photo 3 of 3 : UCIP\_SP\_2021\_62092\_59719.jpg

Concrete headwall and channel on LS toe.

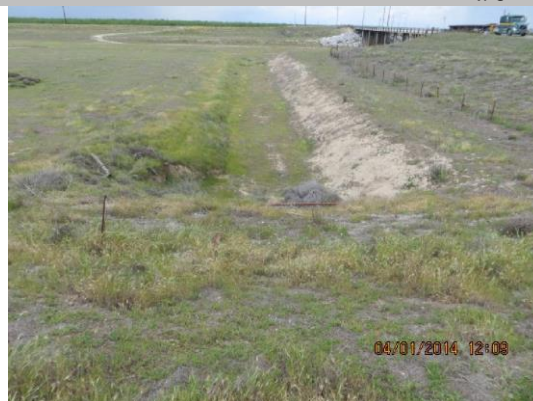
Photo 1 of 3 : UCIP\_SP\_2021\_62093\_59723.jpg

FS\_ID:62093  
DS\_ID:19917  
EP\_NO: N/A  
Repair Type: Non-Urgent  
Crossing Status: Found  
UCIP Comments: 04/01/2014 Dense vegetation limits the inspector's visibility to identify signs of pipe failure (leaks) along the landward slope. Recommend removing vegetation along pipe alignment to conduct proper inspection of structure. (W. Wylie - DWR UCIP)  
FIELD\_STRUCT\_DESC: 48-inch by 60-inch reinforced concrete box gravity drainage culvert through the levee, 15 feet below the crown. Concrete headwall on the landside (LS) end. Concrete U-shaped headwall on the waterside (WS) end. [Additional Reference(s): DWR Levee Log, 2002 (HLM 9.89), listed as a 48-inch by 60-inch reinforced concrete box culvert (RCBC). USACE San Joaquin O&M Manual, Unit 601 Part 1 (SJR601.1), 1967, (HLM 9.89), listed as a 5-feet by 4-feet RCBC].  
FS Date: 4/1/2014

Concrete headwall and channel on WS toe.

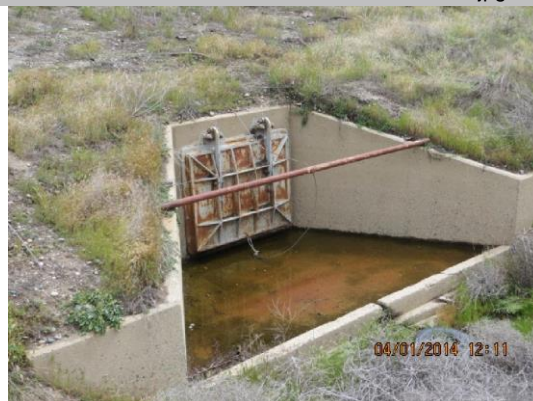
Photo 2 of 3 : UCIP\_SP\_2021\_62093\_59724.jpg

Flapgate on Concrete headwall at WS toe.

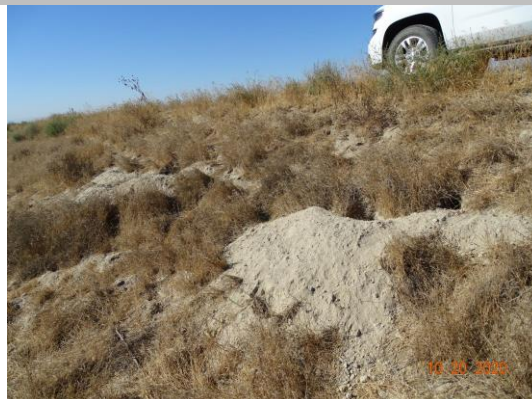
Photo 1 of 1 : SP\_2021\_NA0010\_135\_19\_20210308\_00009.jpg

LM Start	12.25	Rating **	U	Issue No.	19
LM End	12.25	Issue Type +	Ma	Location *	LS
Category	Earthen Levee			GPS Latitude/Longitude	
				Start	End
Item	Animal Control			36.821776 °	36.821776 °
				-120.300137 °	-120.300137 °
DWR ID	DWR_NA0010_17_f_2020_19				
Comment Code					
A3 : No rodents visible, but rodent burrows visible; need to backfill and compact or grout burrows.					
Inspector Comment

View of rodent burrows on the landside slope. (Fall 2020)

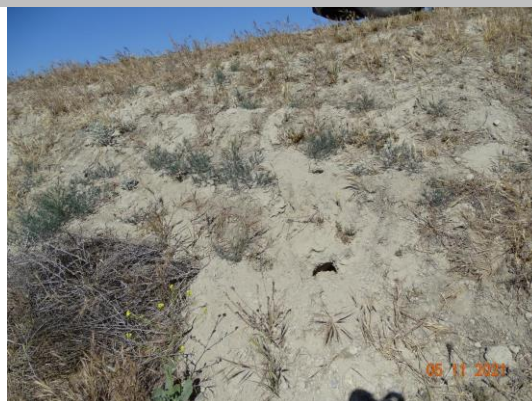
Photo 1 of 1 : SP\_2021\_NA0010\_135\_3\_20210520\_00038.jpg

LM Start	12.28	Rating **	M	Issue No.	3
LM End	12.32	Issue Type +	Ma	Location *	LS
Category	Earthen Levee			GPS Latitude/Longitude	
				Start	End
Item	Animal Control			36.821368 °	36.820843 °
				-120.300283 °	-120.300469 °
DWR ID	DWR_NA0010_17_s_2014_3				
Comment Code					
A3 : No rodents visible, but rodent burrows visible; need to backfill and compact or grout burrows.					
Inspector Comment

View of multiple rodent holes in the landside slope. (Spring 2021)

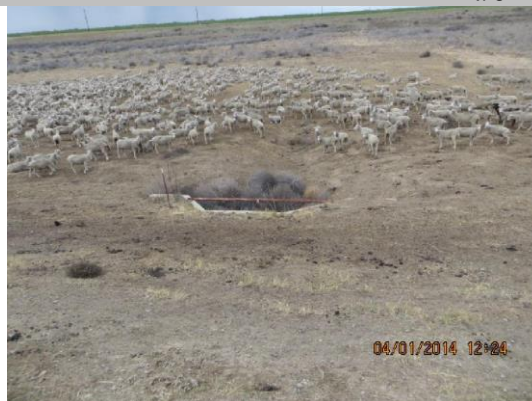
Photo 1 of 3 : UCIP\_SP\_2021\_62094\_59727.jpg

Comment Code						
Inspector Comment						
FS_ID:62094						
DS_ID:19918						
EP_NO: N/A						
Repair Type: Non-Urgent						
Crossing Status: Found						
UCIP Comments: 04/01/2014 Some vegetation buildup at inlet--recommend clearing. (W. Wylie - DWR UCIP)						
FIELD_STRUCT_DESC: 48-inch by 60-inch reinforced concrete box gravity drainage culvert through the levee, 15.3 feet below the crown. Flap gate on the waterside (WS) end. Concrete headwall on the landside (LS) end. Concrete U-shaped headwall on the WS end. [Additional Reference(s): DWR Levee Log, 2002 (HLM 13.29), listed as a 48-inch by 60-inch reinforced concrete box culvert (RCBC). USACE San Joaquin O&M Manual, Unit 601 Part 1 (SJR601.1), 1967, (HLM 13.30), listed as a 5-feet by 4-feet RCBC].						
FS Date: 4/1/2014

Concrete headwall on WS toe.

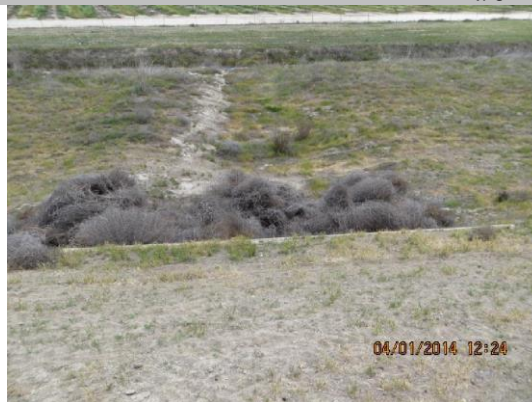
Photo 2 of 3 : UCIP\_SP\_2021\_62094\_59726.jpg

Concrete headwall on LS toe.

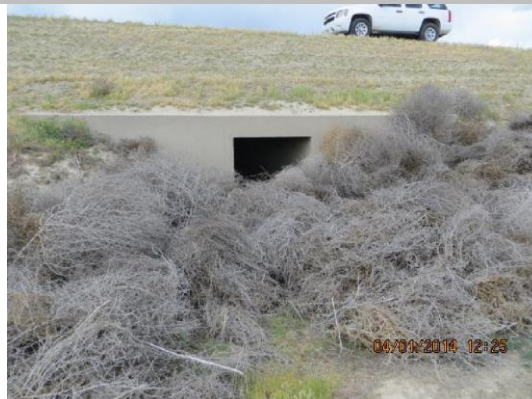
Photo 3 of 3 : UCIP\_SP\_2021\_62094\_59725.jpg

Concrete headwall on LS toe. Some vegetation buildup.

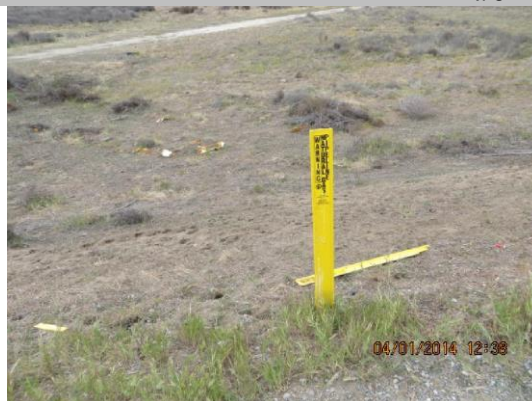
Photo 1 of 3 : UCIP\_SP\_2021\_62095\_71490.jpg

FS\_ID:62095  
 DS\_ID:24850  
 EP\_NO: N/A  
 Repair Type: Non-Urgent  
 Crossing Status: Indicator Found  
 UCIP Comments: 04/01/2014 No permit identified for this crossing. (W. Wylie - DWR UCIP)  
 FIELD\_STRUCT\_DESC: Natural gas pipeline of an unknown size or material through the levee, at an unknown depth. Gas line markers on both shoulders.  
 FS Date: 4/1/2014

Gasline marker on WS slope..

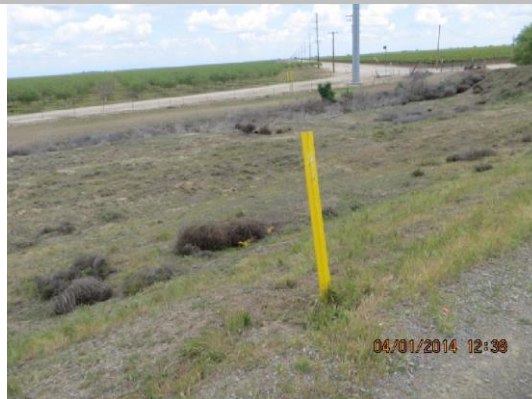
Photo 2 of 3 : UCIP\_SP\_2021\_62095\_71489.jpg

Gasline marker on LS shoulder.

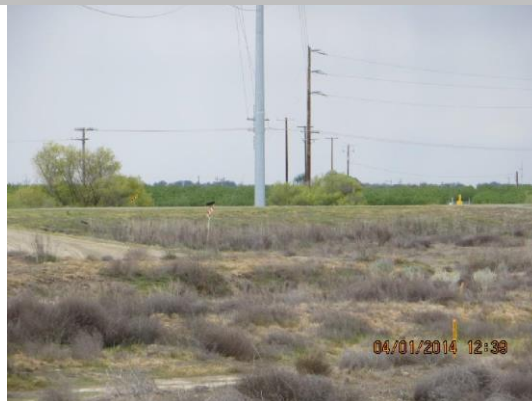
Photo 3 of 3 : UCIP\_SP\_2021\_62095\_71488.jpg

Gasline markers visible along right side of photo.

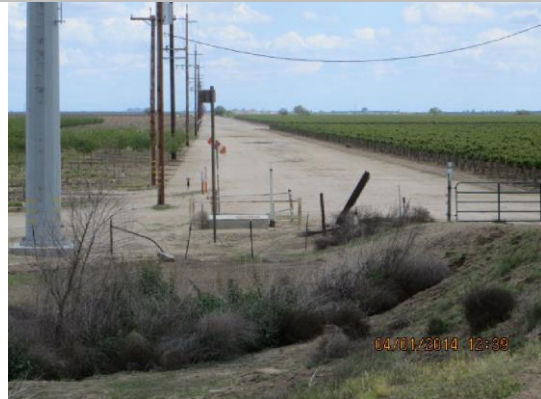
Photo 1 of 3 : UCIP\_SP\_2021\_62096\_59742.jpg

Comment Code					
Inspector Comment					
FS_ID:62096 DS_ID:19562 EP_NO: 18568 Repair Type: Non-Urgent Crossing Status: Indicator Found UCIP Comments: 7/20/2016 Marker visible on LS. WS marker missing. (O. Magana - DWR UCIP)4/01/2014 Need to contact owner to confirm and obtain status of crossing. Markers misleading--unable to confirm if markers correspond to this crossing. Need markers at levee. (W. Wylie) FIELD_STRUCT_DESC: 30-inch coated steel natural gas pipeline through the levee, approximately 60 feet below the crown. Gas line markers are visible on the waterside (WS) and the landside (LS). (30-inch horizontal directional bore (HDD) authorized under Permit No. 18568, 2010 - Gill Ranch Storage, LLC). FS Date: 7/20/2016

Gasline marker and concrete sump off LS toe.

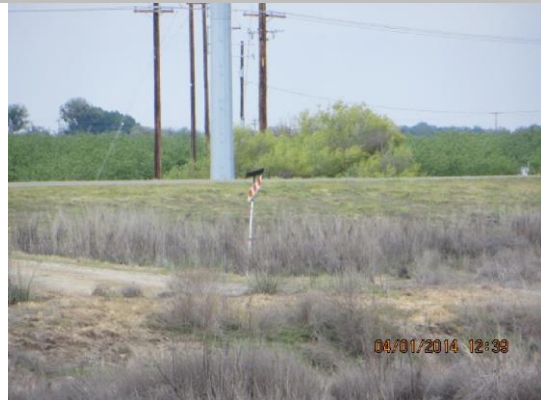
Photo 2 of 3 : UCIP\_SP\_2021\_62096\_59741.jpg

Gasline marker visible in channel off WS toe.

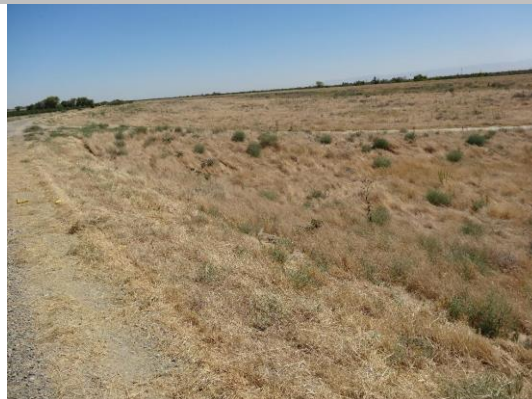
Photo 3 of 3 : UCIP\_SP\_2021\_62096\_75506.jpg

View of WS.

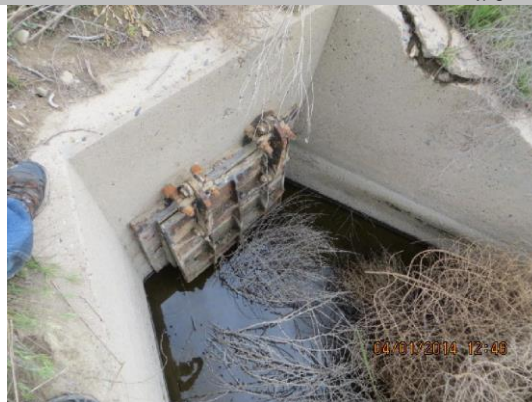
Photo 2 of 3 : UCIP\_SP\_2021\_62098\_59747.jpg

Flapgate on Concrete headwall at WS toe.

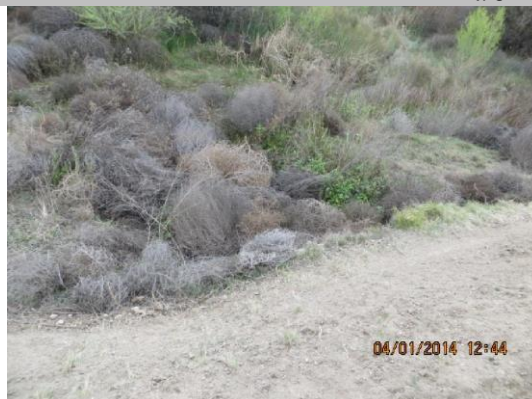
Photo 3 of 3 : UCIP\_SP\_2021\_62098\_59746.jpg

Comment Code					
Inspector Comment					
FS_ID:62098					
DS_ID:19920					
EP_NO: N/A					
Repair Type: Non-Urgent					
Crossing Status: Found					
UCIP Comments: 04/01/2014 Heavy vegetation buildup at LS toe-- recommend clearing. (W. Wylie - DWR UCIP)					
FIELD_STRUCT_DESC: 30-inch by 30-inch square reinforced concrete box gravity drainage culvert through the levee, 14 feet below the crown. Flap gate on the waterside (WS) end. Concrete headwall on the landside (LS) end. Concrete U-shaped headwall on the WS end. [Additional Reference(s): DWR Levee Log, 2002 (HLM 14.70), listed as a 30-inch square reinforced concrete box culvert (RCBC). USACE San Joaquin O&M Manual, Unit 601 Part 1 (SJR601.1), 1967, (HLM 14.69), listed as a 2.5-feet by 2.5-feet RCBC].					
FS Date: 4/1/2014

Concrete headwall at channel on LS toe. Heavy vegetation buildup.

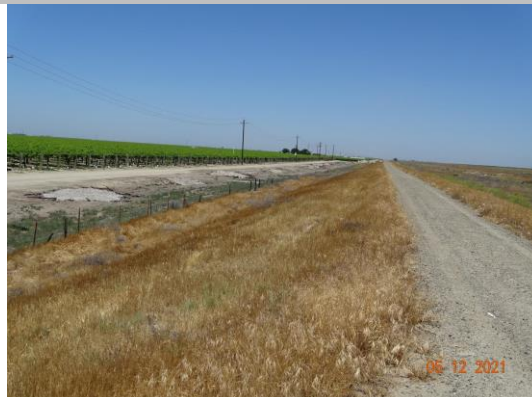
Photo 1 of 1 : SP\_2021\_NA0010\_137\_12\_20210520\_00029.jpg

LM Start	0.00	Rating **	M	Issue No.	12
LM End	4.85	Issue Type +	Ma	Location *	LS
Category	Earthen Levee			GPS Latitude/Longitude	
				Start	End
Item	Vegetation			36.974171 °	36.909443 °
				-120.363331 °	-120.333730 °
DWR ID	DWR_NA0010_18_s_2021_12				
Comment Code					
V1 : Control annual grass and weeds on the levee slopes and easements.					
Inspector Comment

Looking downstream along the landside slope. (Spring 2021)

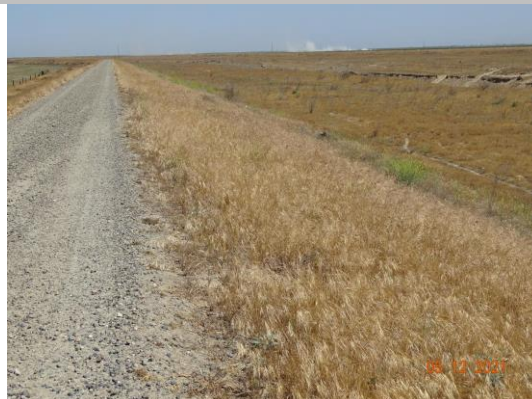
Photo 1 of 1 : SP\_2021\_NA0010\_137\_10\_20210520\_00030.jpg

LM Start	0.00	Rating **	M	Issue No.	10
LM End	7.30	Issue Type +	Ma	Location *	WS
Category	Earthen Levee			GPS Latitude/Longitude	
				Start	End
Item	Vegetation			36.974171 °	36.875857 °
				-120.363331 °	-120.320079 °
DWR ID	DWR_NA0010_18_s_2021_10				
Comment Code					
V1 : Control annual grass and weeds on the levee slopes and easements.					
Inspector Comment

Looking downstream along the waterside slope. (Spring 2021)

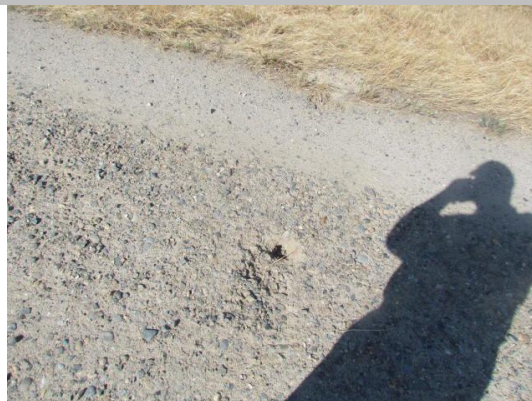
Photo 1 of 1 : SP\_2021\_NA0010\_137\_7\_20210308\_00003.jpg

LM Start	1.44	Rating **	M	Issue No.	7
LM End	1.44	Issue Type +	Ma	Location *	LS
Category	Earthen Levee			GPS Latitude/Longitude	
				Start	End
Item	Animal Control			36.956163 °	36.956163 °
				-120.353672 °	-120.353672 °
DWR ID	DWR_NA0010_18_f_2018_7				
Comment Code					
A3 : No rodents visible, but rodent burrows visible; need to backfill and compact or grout burrows.					
Inspector Comment					
There are several rodent holes identified on landside slope and on the levee crown.

Looking at typical view of rodent holes within this section on landward slope.
